708P91368
September 2017

Xerox® AltaLink® B8090 Family Multifunction Printer Service Manual

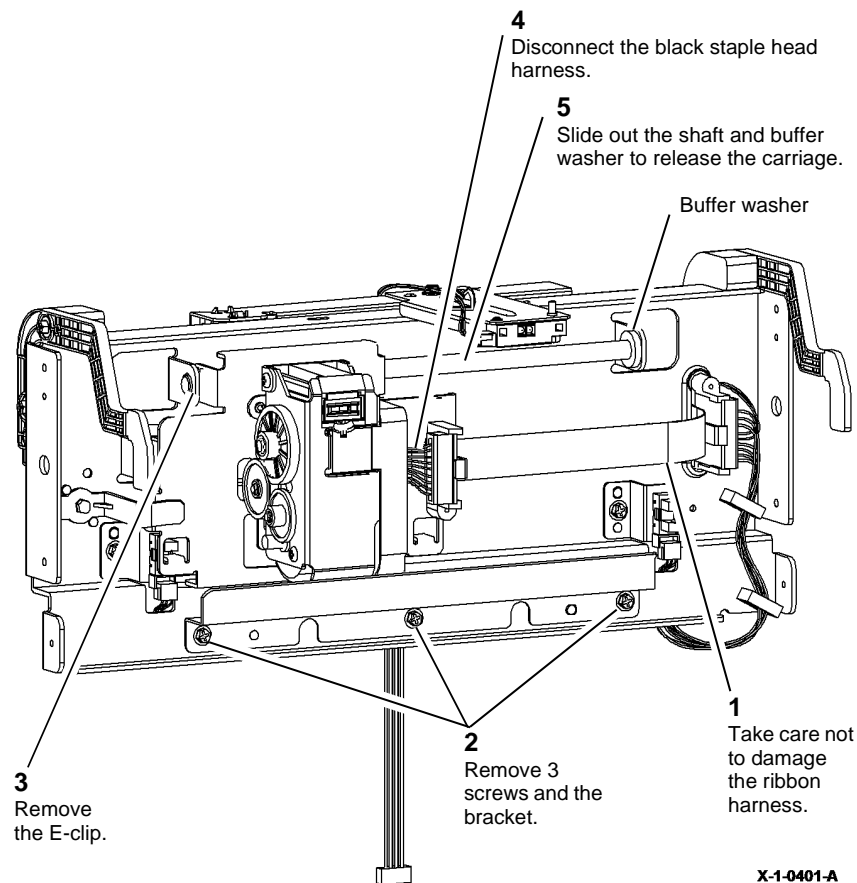
3. Prepare to remove the stapler carriage assembly, [Figure 2](#).

Figure 2 Preparation

1. Refer to [GP 6](#) before refitting the screws.
2. Ensure that the buffer washer is installed in the correct position, refer to [Figure 2](#).
3. The replacement is the reverse of the removal procedure.
4. Perform the adjustments that follow:
 - [ADJ 12.6-150](#) Booklet Stapler Anvil Position - Front
 - [ADJ 12.7-150](#) Booklet Stapler Anvil Position - Rear.

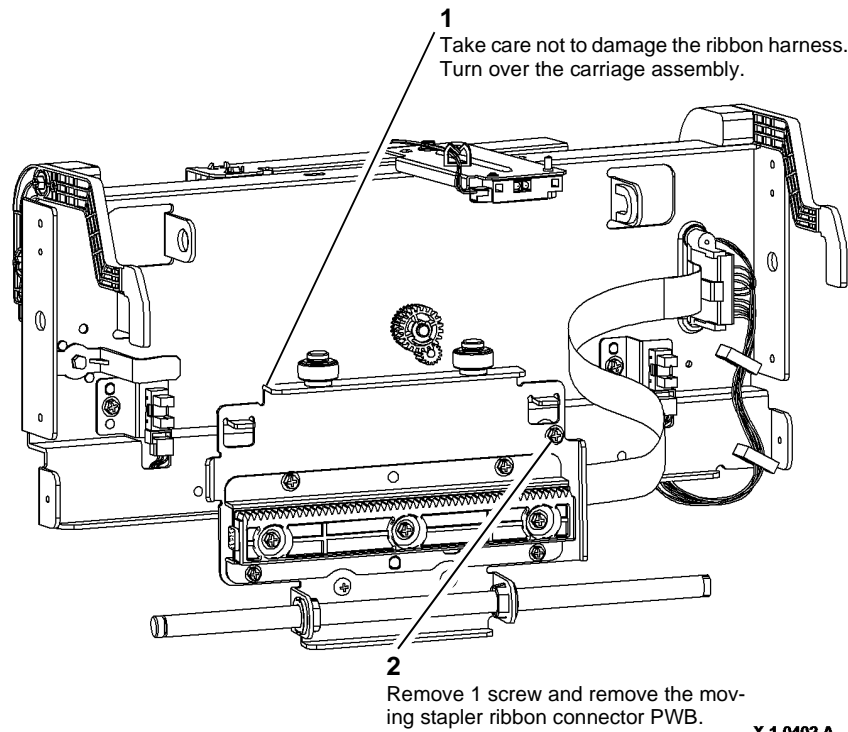
4. Remove the stapler carriage assembly, [Figure 3](#).

Figure 3 Carriage removal

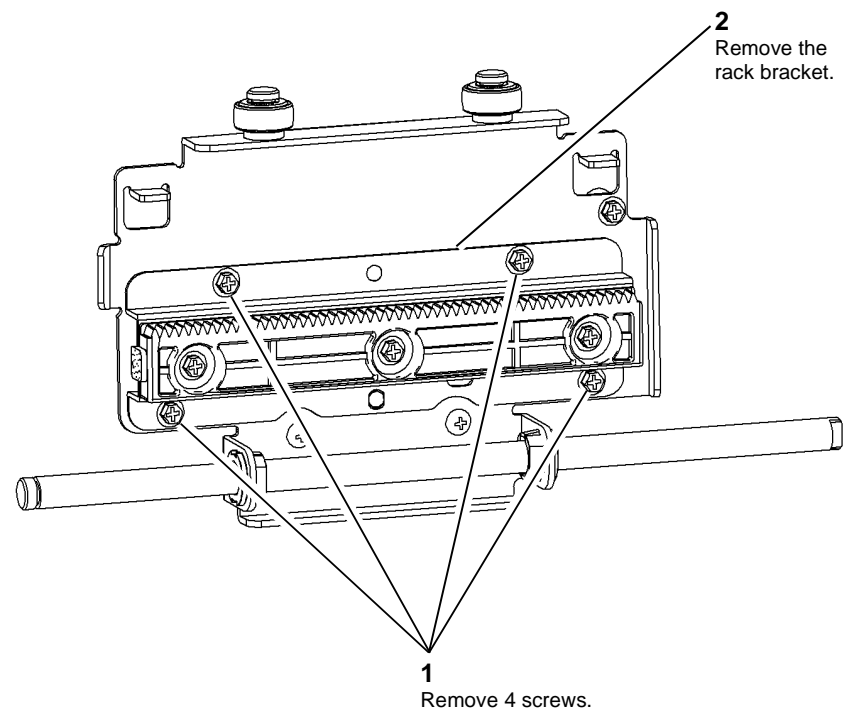
5. Remove the rack bracket, [Figure 4](#).

Figure 4 Rack bracket removal

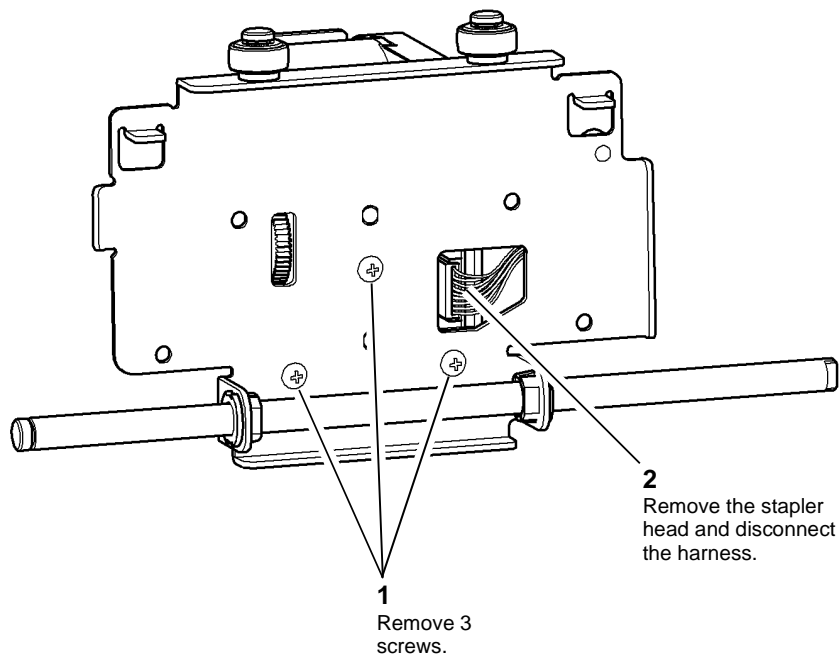
X-1-0404-A

6. Remove the BM stapler head assembly, [Figure 5](#).

Figure 5 Head assembly removal

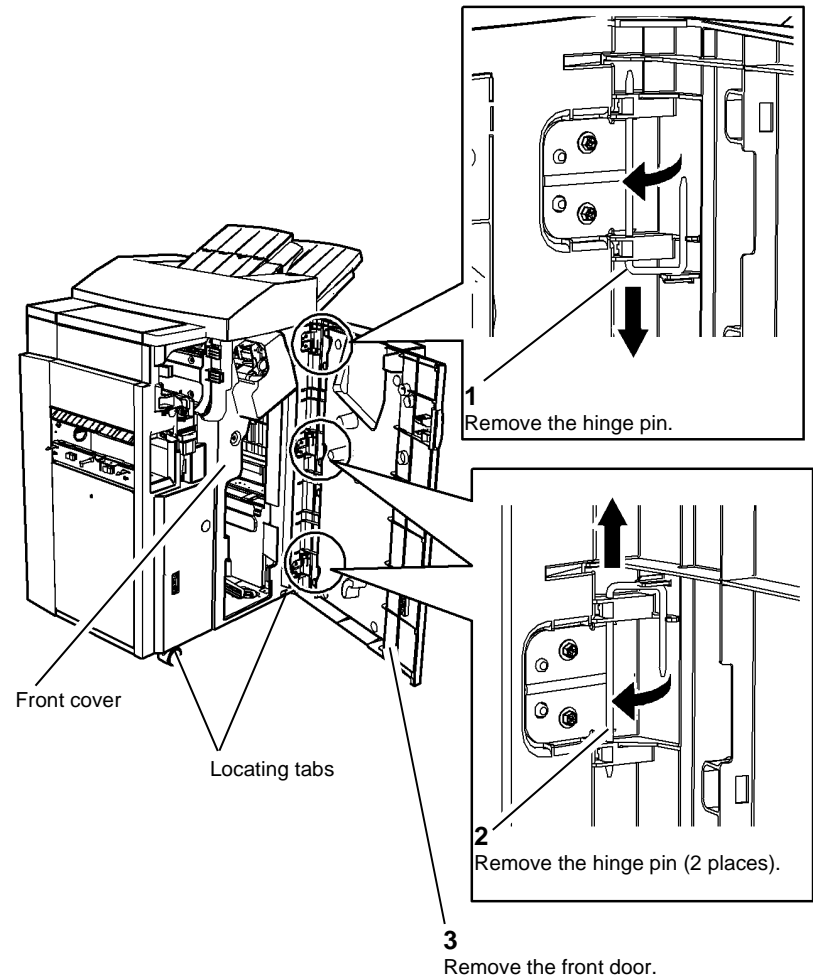
1. Remove the front door, [Figure 1](#). If required, remove 5 screws to separate the door support from the front door.

Figure 1 Front door removal

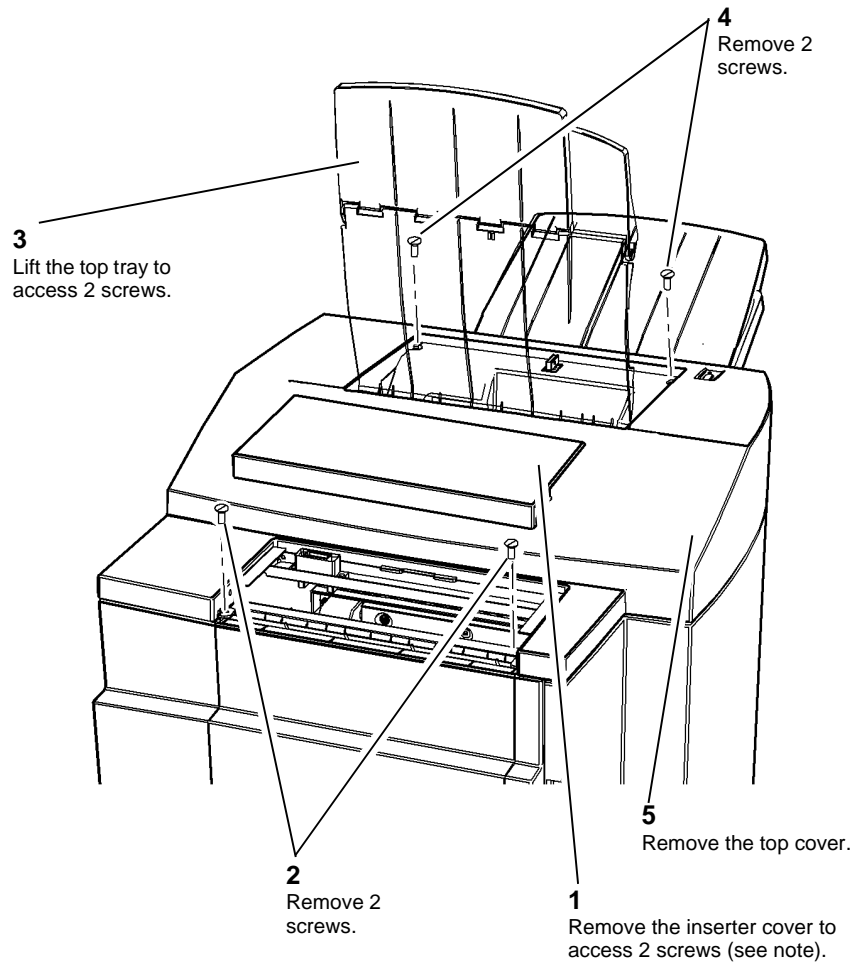
X-1-0406-A

2. Remove the top cover, [Figure 2](#).

NOTE: In step 1 remove the Inserter unit if fitted (See [REP 12.82-171](#)), or remove the Inserter removable cover, [PL 12.100 Item 8](#).

Figure 2 Top cover removal

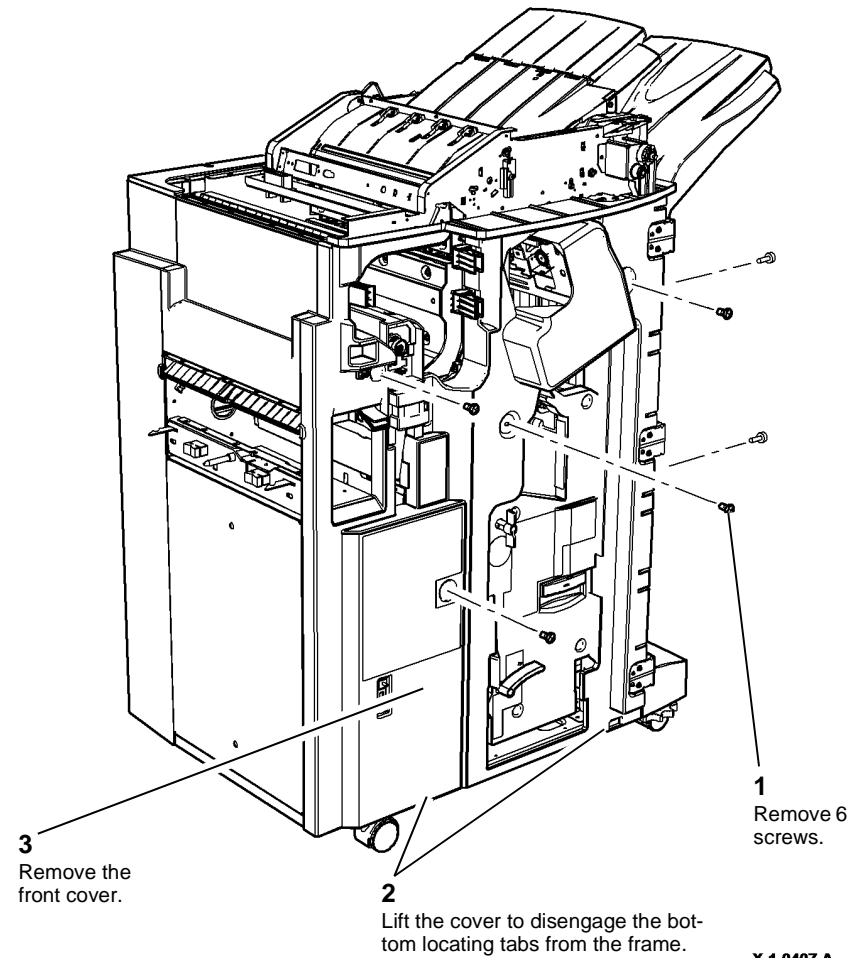
X-1-0407-A

3. Remove the front cover, [Figure 3](#).

NOTE: The top cover must be removed before removing the front cover.

Figure 3 Front cover removal

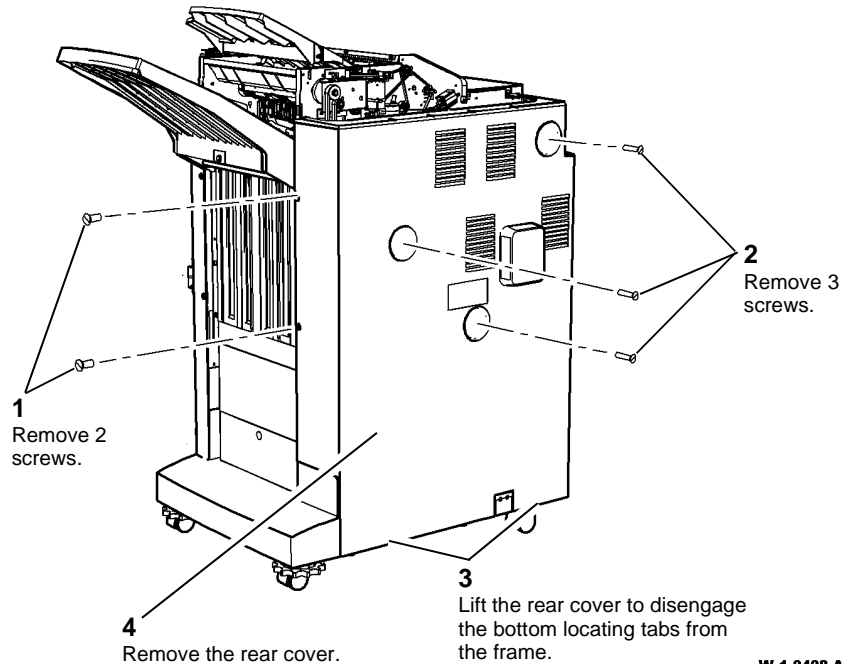
- Remove the rear cover, [Figure 4](#).

NOTE: The top cover must be removed before removing the rear cover.

Figure 4 Rear cover removal

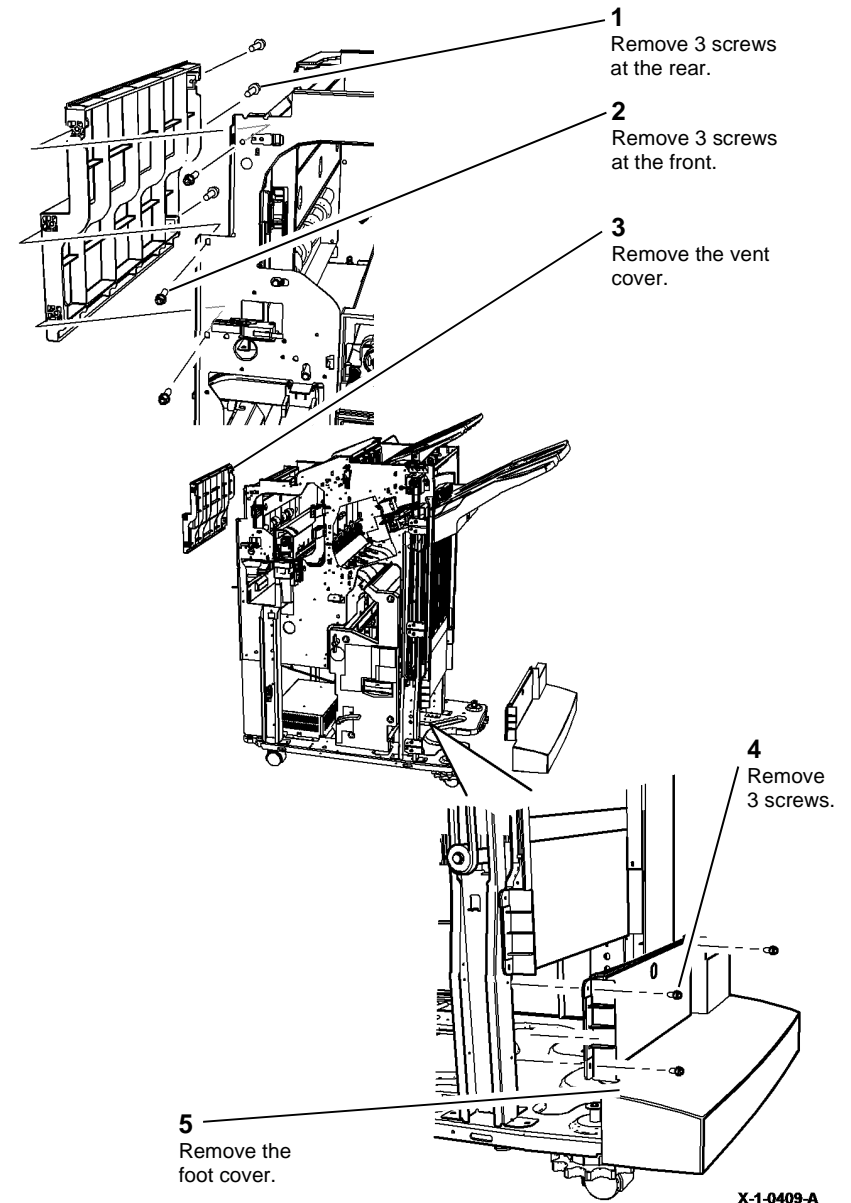
- Remove the vent cover and foot cover, [Figure 5](#). To provide enough room to remove the vent cover, un-dock the HVF, [REP 12.13-171](#).

NOTE: The top front cover and rear cover must be removed before removing the vent cover and foot cover.

NOTE: The foot cover is not installed if the tri-folder option is installed.

Figure 5 Vent and foot covers removal

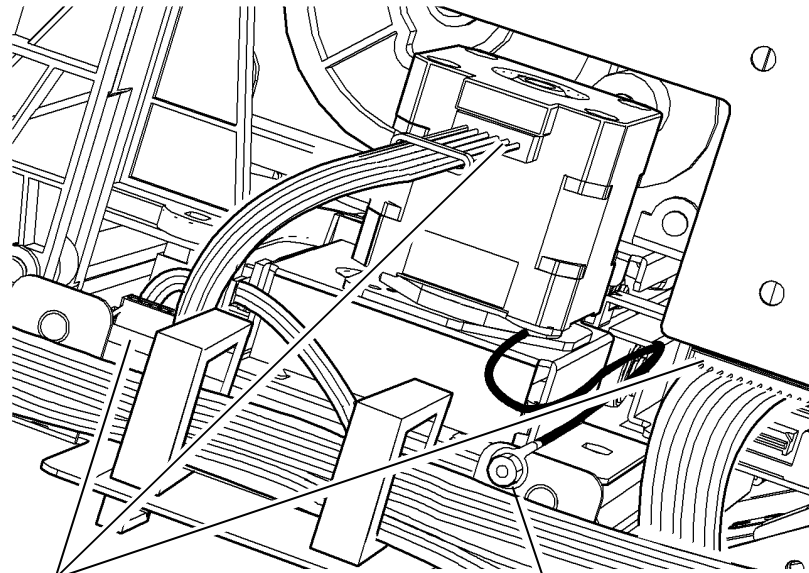
7. **Figure 1.** At the rear of the HVF, prepare to remove the stapler assembly.

1
Disconnect three PJs.

2
Remove the ground
wire screw.

Figure 1 Preparation

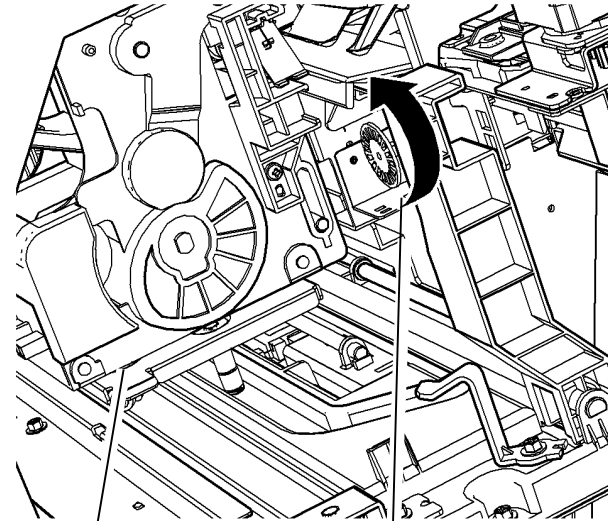
8. **Figure 2.** Move the ejector unit to the out position.

1
Move the stapler to
gain access.

2
Turn the encoder wheel to move
the ejector unit to the out position

Figure 2 Ejector move

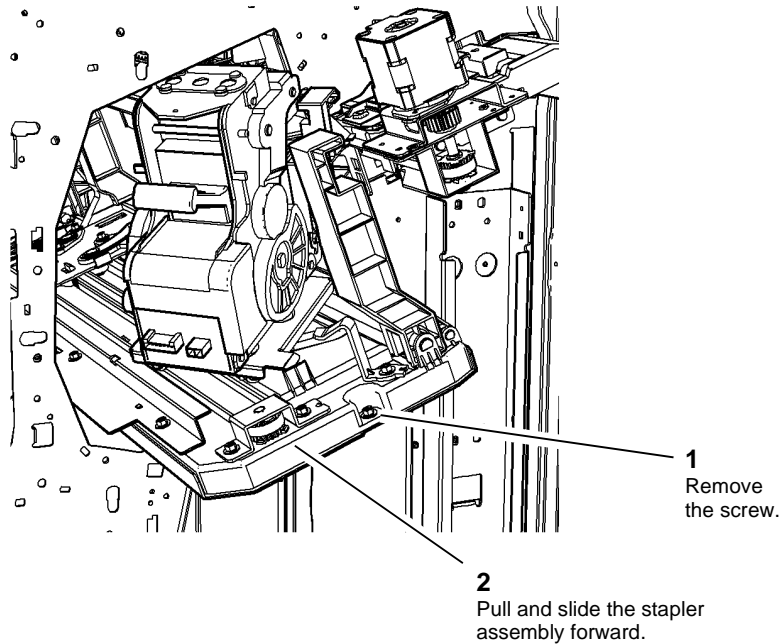
X-1-0412-A

9. [Figure 3](#). Remove the stapler assembly.

Figure 3 Stapler removal

1. Slide the stapler assembly into the tray, taking care not to trap the ground wire at the rear.
2. The remainder of the replacement procedure is the reverse of the removal procedure.

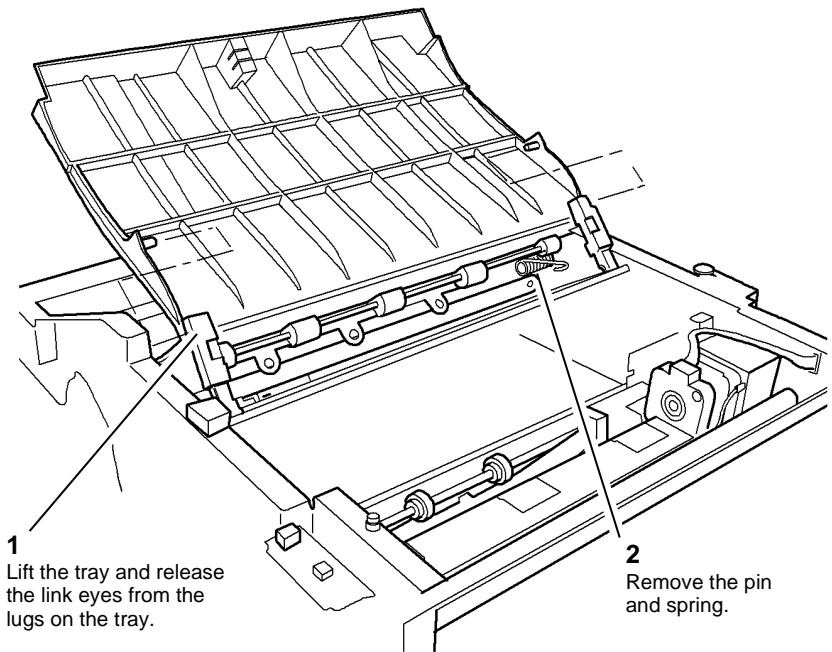
X-1-0413-A

1. If fitted, un-dock the Inserter, [REP 12.82-171](#).
2. Remove the top and rear covers [REP 12.1-171](#).
3. Prepare to remove the top tray, [Figure 1](#).

Figure 1 Preparation

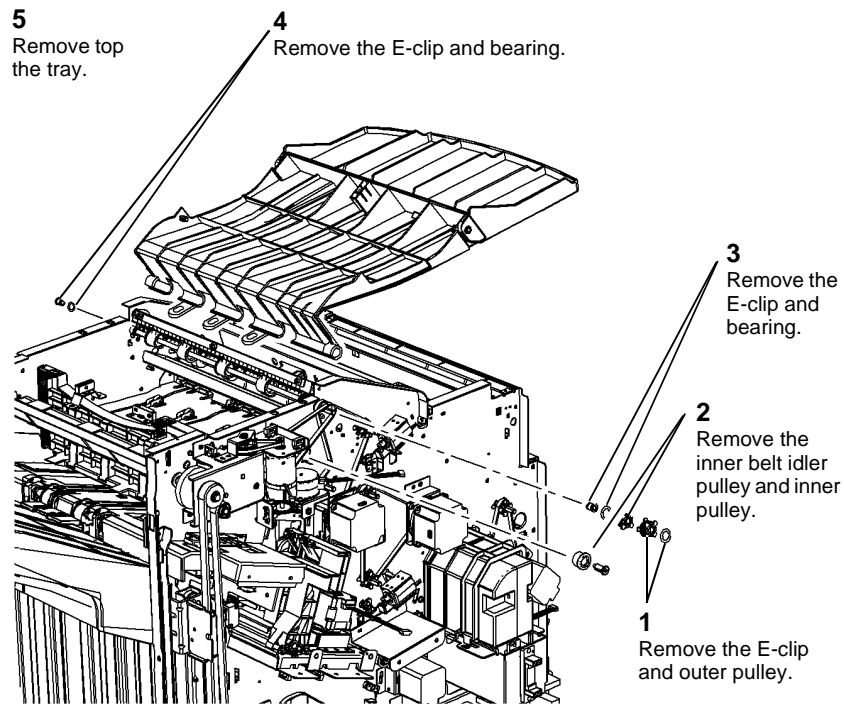
4. Remove the top tray, [Figure 2](#).

Figure 2 Top tray removal

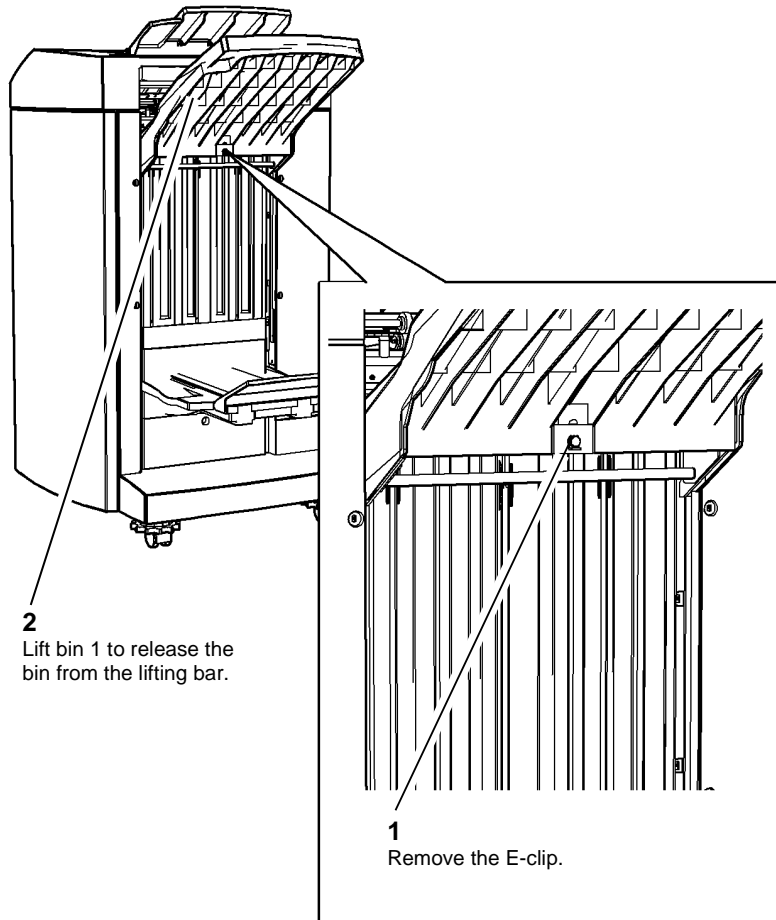
X-1-0415-A

1. Remove Bin 1. [Figure 1](#).

Figure 1 Bin 1 removal

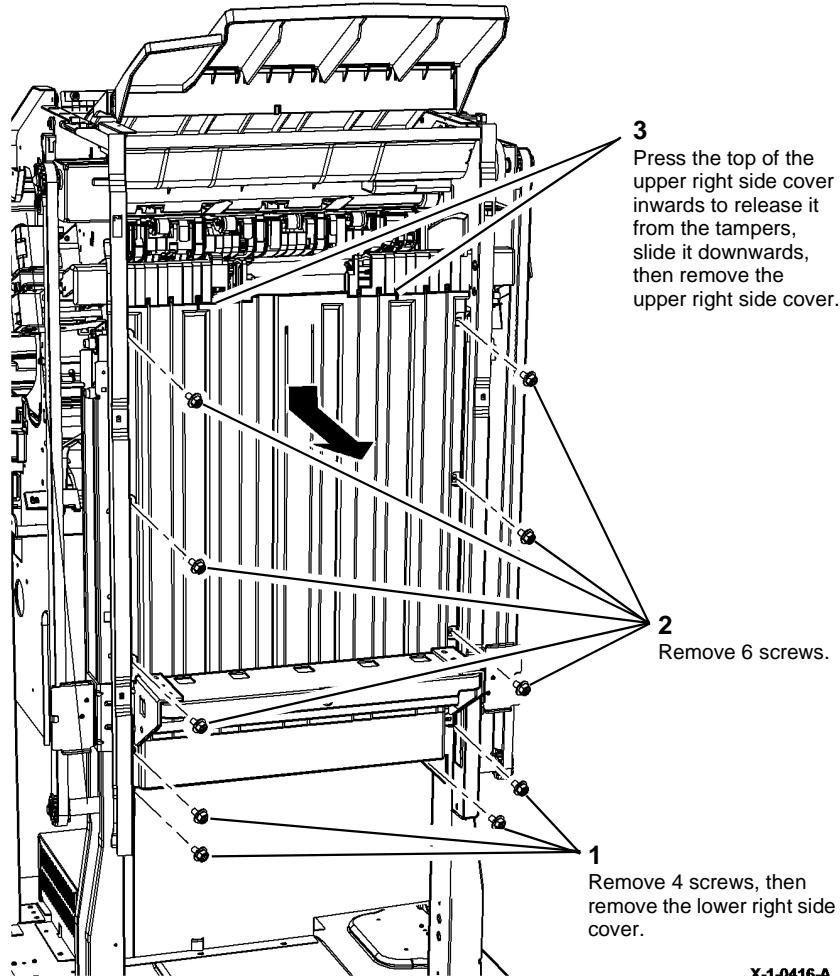
X-1-0416-A

3. Remove the lower right side cover and upper right side cover, [Figure 1](#).

Figure 1 Covers removal

1. With the machine powered on, use [dC330](#) code 12-242 to lower Bin 1 to the position shown in [Figure 1](#).
2. Remove Bin 1, [REP 12.4-171](#).

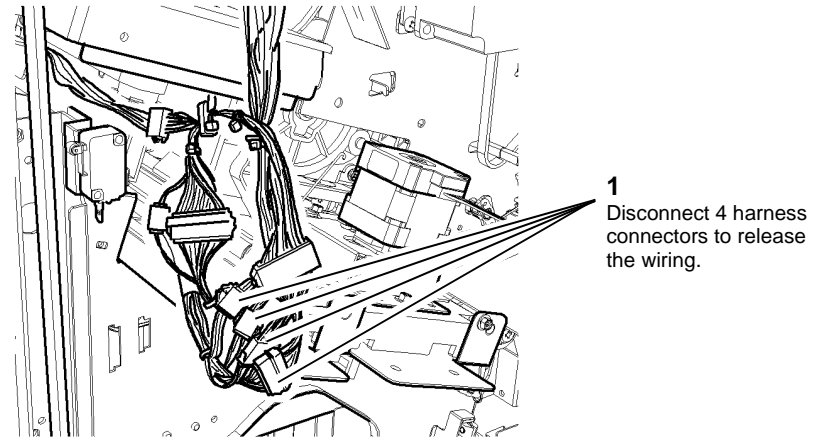
X-1-0417-A

1. Remove the upper right side cover [REP 12.5-171](#).
2. Remove the rear cover [REP 12.1-171](#).
3. Remove the front and rear pressing plate finger, [REP 12.7-171](#).
4. Disconnect the harnesses, [Figure 1](#).

Figure 1 Harness disconnection

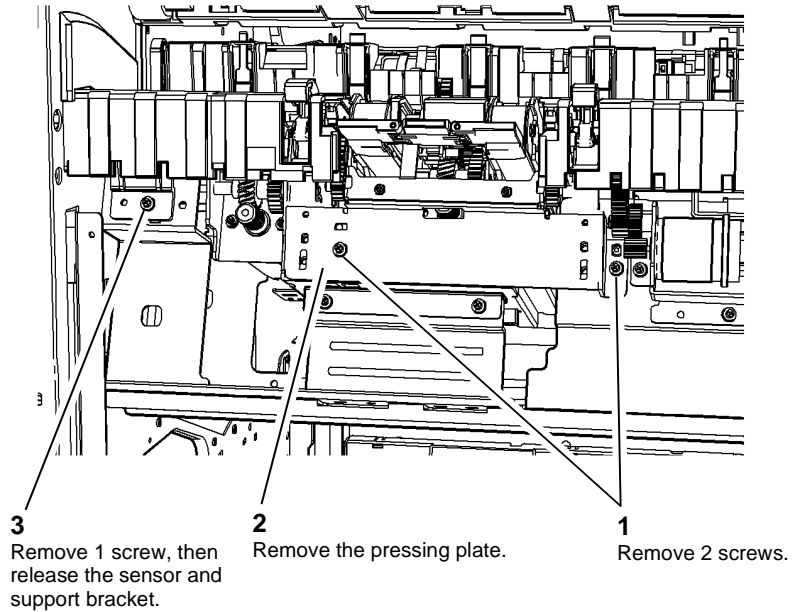
X-1-0418-A

5. Remove the pressing plate and sensor support bracket. [Figure 2.](#)

Figure 2 Pressing plate removal

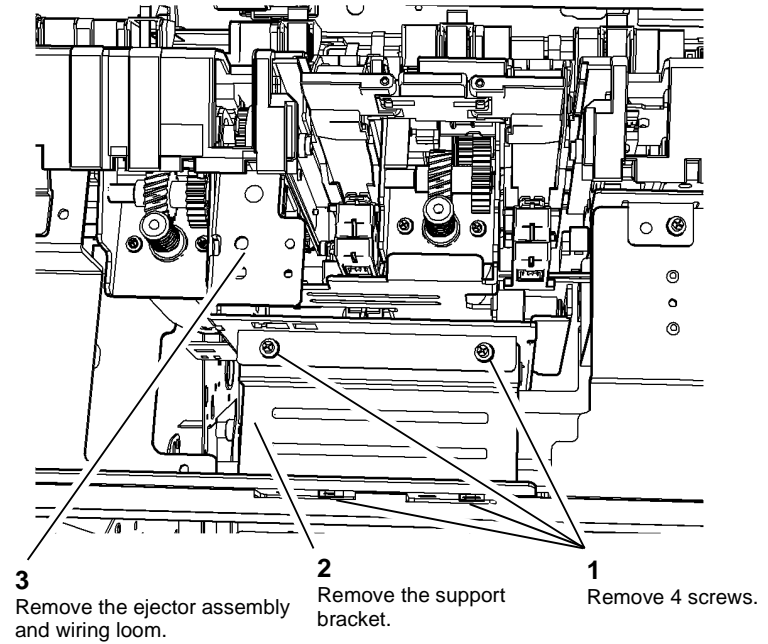
X-1-0419-A

6. Remove the support bracket and ejector assembly, [Figure 3.](#)

Figure 3 Ejector assembly removal

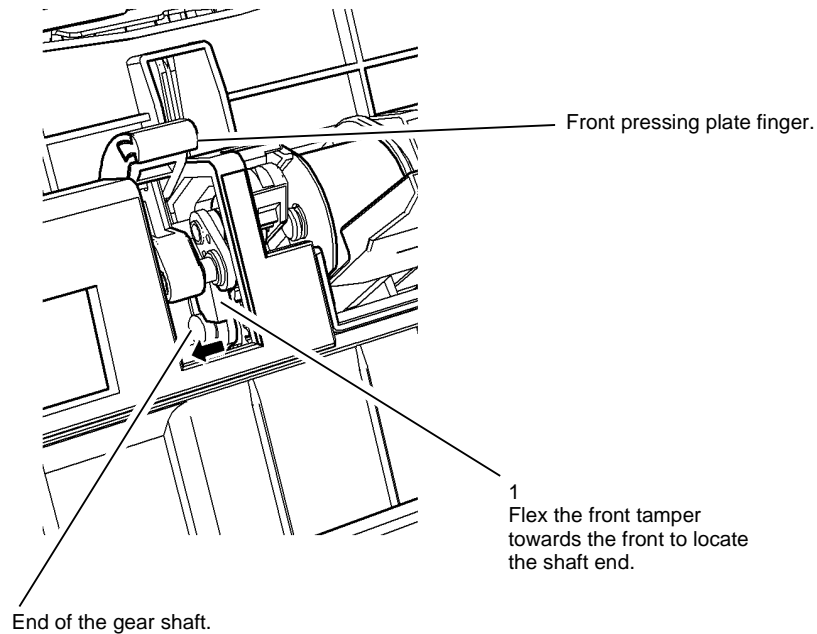
X-1-0420-A

1. When reinstalling the eject assembly ensure that the tag on the ejector locates into the slot in the frame.
2. Ensure the front and rear support fingers are fully pushed home. See [REP 12.8-171](#).
3. When refitting the pressing plate, the shaft of the front support finger drive gear must fit in the hole of the front tamper see [Figure 4](#). Install the front pressing plate finger.

Figure 4 Pressing plate install

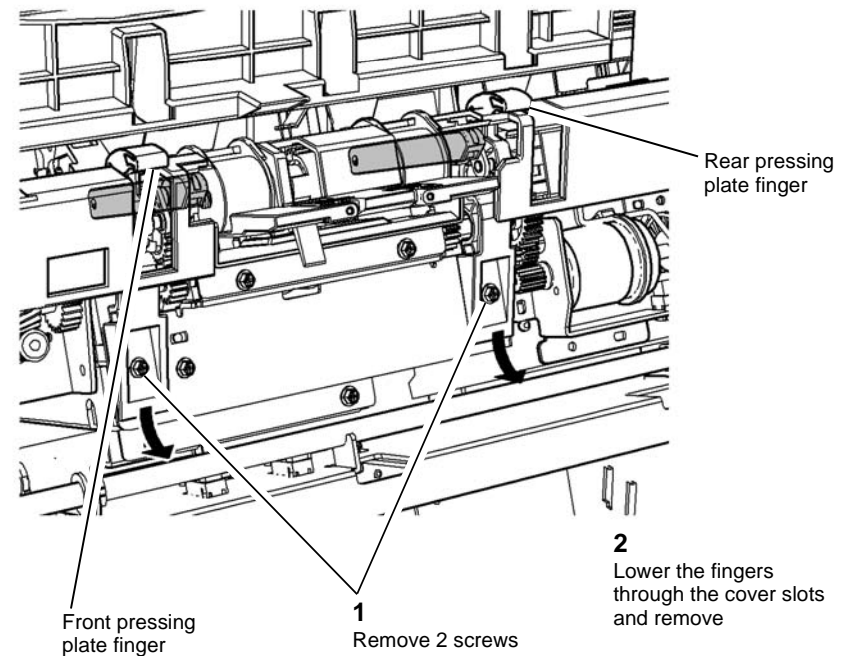
X-1-0421-A

1. Remove the upper right side cover [REP 12.5-171](#).
2. Remove the pressing plate fingers, [Figure 1](#).

Figure 1 Pressing Plate Fingers

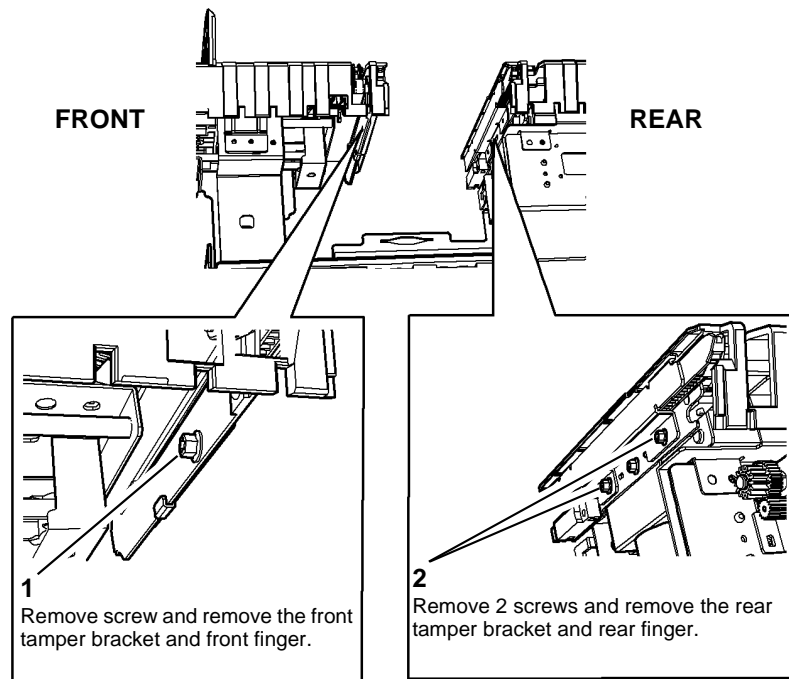
X-1-0422-A

Figure 1 Support fingers removal

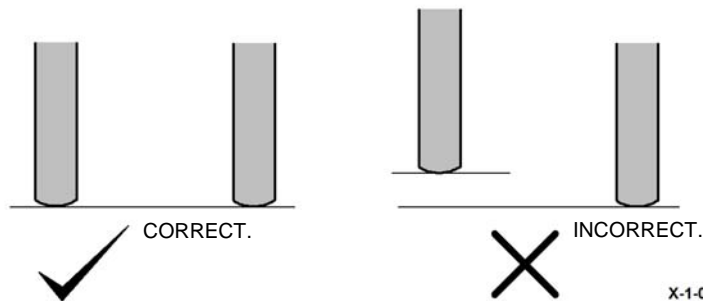
1. When installing the front and rear support fingers, ensure that the pegs on the inner end of the fingers are fully inserted into the guide slots on the inboard ends of the front and rear tampers.
2. After tightening the fixing screws of the front and rear tamper brackets, ensure that the front and rear support fingers can slide freely in and out, before installing the pressing plate. Set the front and rear support fingers so that they are fully inserted in the tamper brackets.
3. When installing the pressing plate, the front of the pressing plate shaft must fit through the hole in the front tamper.
4. Rotate the encoder wheel, [Figure 2](#) to extend the support fingers enough to check that they align correctly, [Figure 2](#). If necessary, perform the steps in [Figure 2](#) to align the fingers.

Figure 2 Support Finger End Alignment

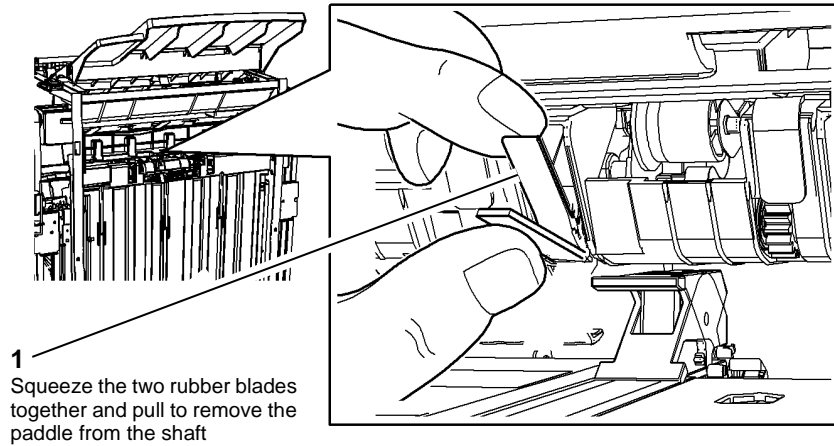
X-1-0593-A

2. Remove the HVF paddles, [Figure 1](#).

Figure 1 Paddle removal

1. Hold the paddle by the two rubber blades and clip onto the shaft.

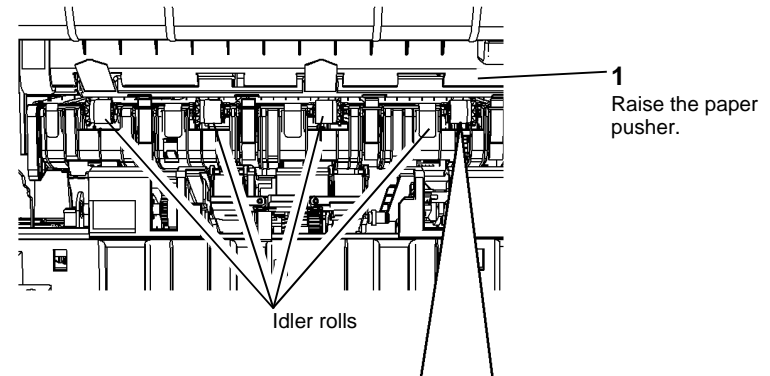
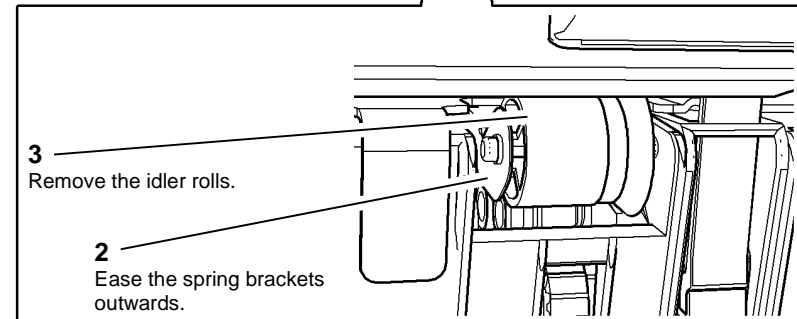
X-1-0424-A

1. Lift the top tray
2. [Figure 1](#). Remove the four stacker idler rolls.

Figure 1 Paper pusher and idler rolls.

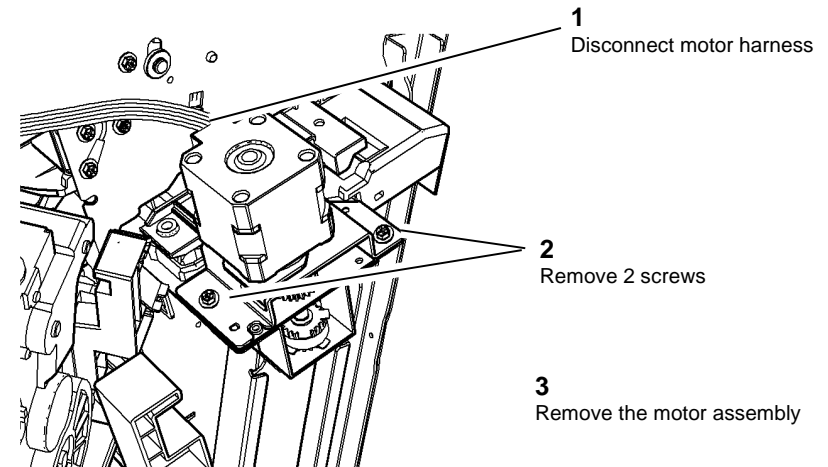
X-1-0426-A

1. Remove the front door and front cover [REP 12.1-171](#).
2. Remove the HVF ejector assembly, [REP 12.6-171](#).
3. Remove the tamper motor assembly, [Figure 1](#).

Figure 1 Tamper motor removal

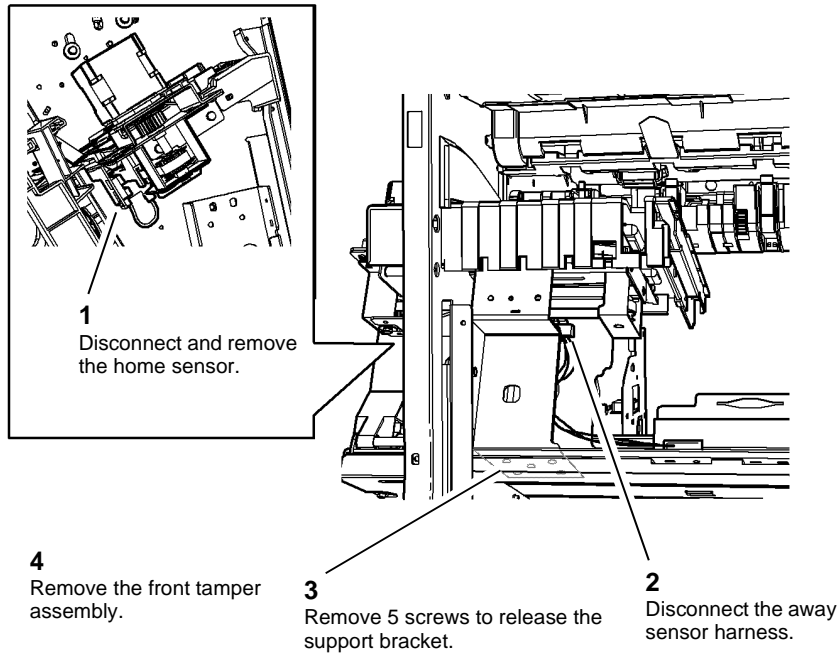
X-1-0427-A

4. Remove the front tamper assembly, [Figure 2](#).

NOTE: The front tamper home sensor is removed to prevent the sensor from being damaged when the front tamper assembly is removed.

Figure 2 Front tamper assembly

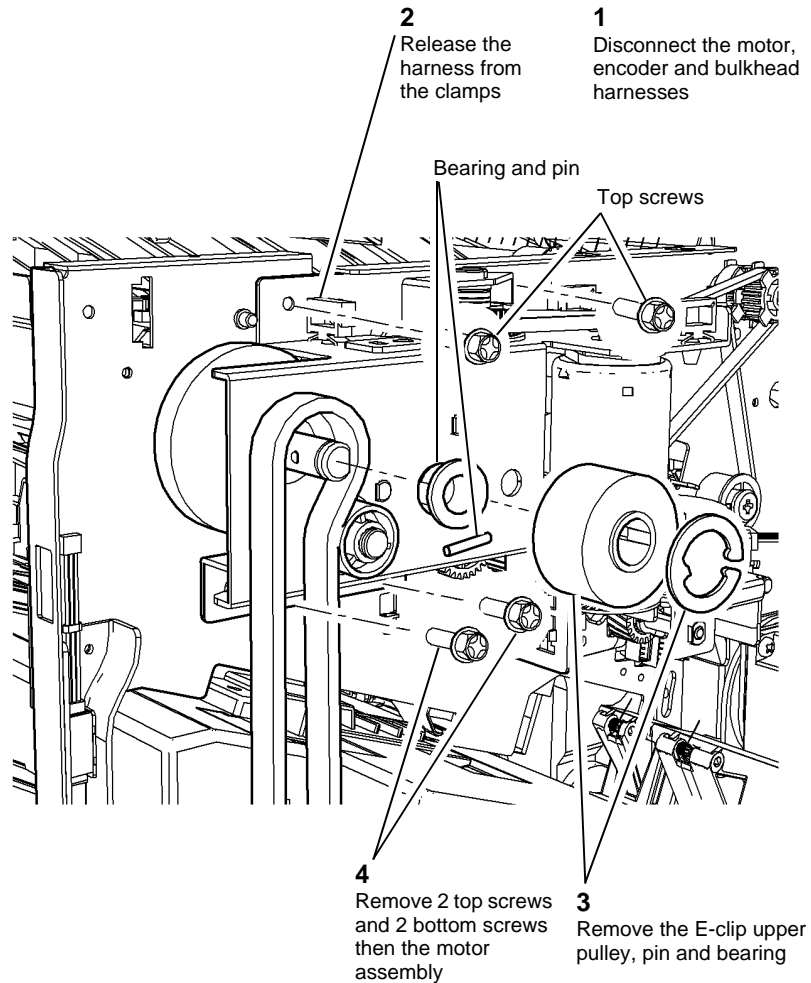
X-1-0428-A

1. Remove the front and rear covers [REP 12.1-171](#).
2. Remove the rear bin 1 main drive belt lower pulley to relieve the belt tension.
3. Remove the bin 1 elevator motor assembly [Figure 1](#).

NOTE: The pulley pin may fall when the pulley is removed.

Figure 1 Motor assembly removal

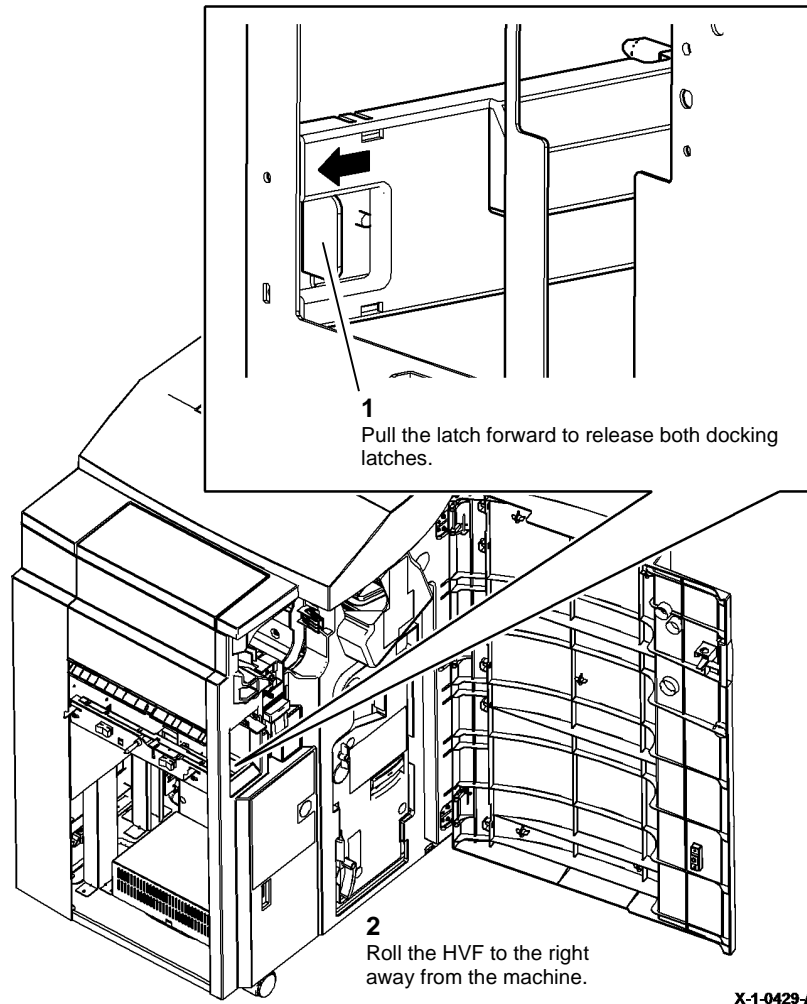
Figure 1 Docking latch release

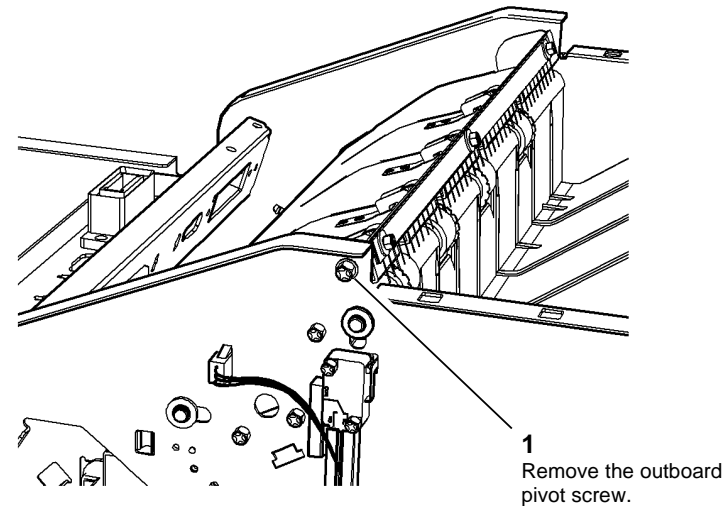
1. Remove the HVF front door, [REP 12.1-171](#).
2. Remove the HVF top cover, [REP 12.1-171](#).
3. Remove the HVF front cover, [REP 12.1-171](#).
4. Remove the HVF rear cover, [REP 12.1-171](#).
5. [Figure 1](#). Remove the outboard pivot screw.

Figure 1 Outboard pivot screw.

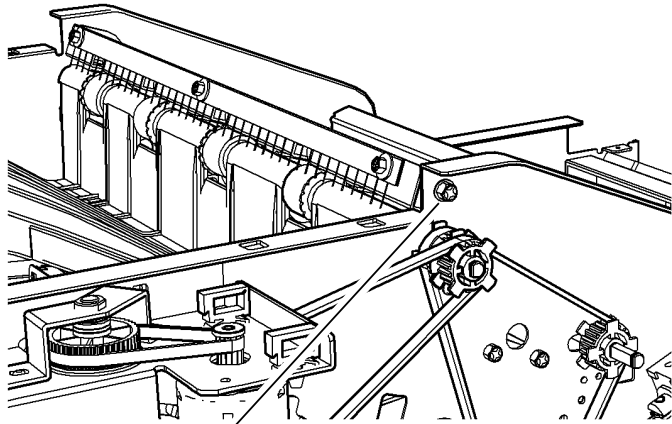
X-1-0431-A

6. **Figure 2.** Remove the inboard pivot screw.

1
Remove the inboard
pivot screw.

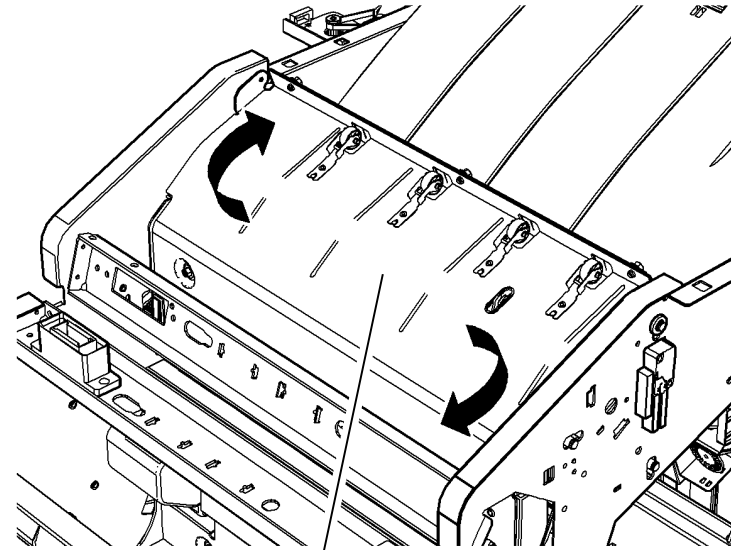
7. **Figure 3.** Remove the upper exit guide.

1
Twist the upper exit guide
and lift upwards.

Figure 3 Upper exit guide removal.

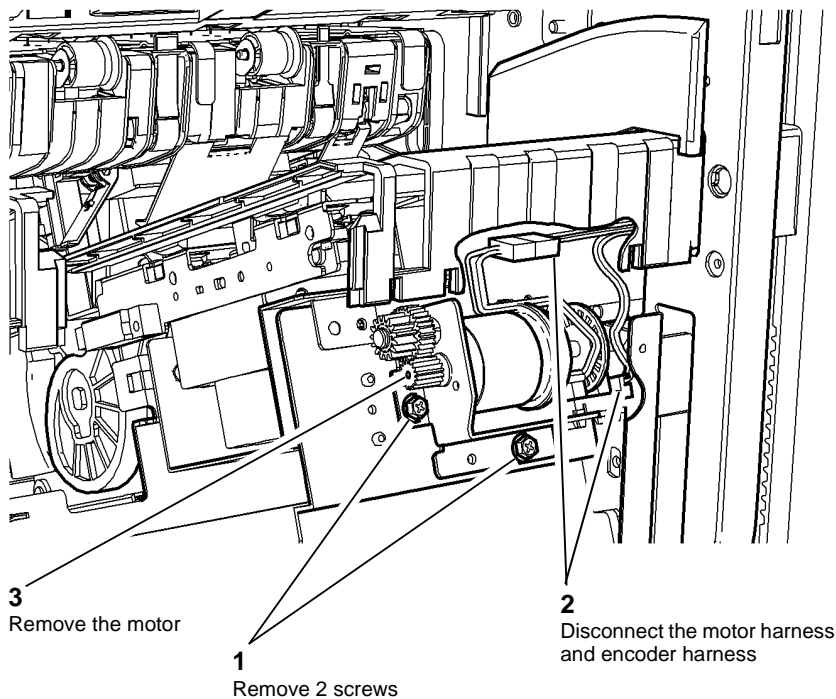
1. Remove the rear cover [REP 12.1-171](#).
2. Remove the upper right side cover [REP 12.5-171](#).
3. Remove the ejector assembly [REP 12.6-171](#).
4. Remove the front tamper assembly, [REP 12.11-171](#).
5. Remove the pressing and support motor, [Figure 1](#).

3
Remove the motor

1
Remove 2 screws

Figure 1 Motor removal

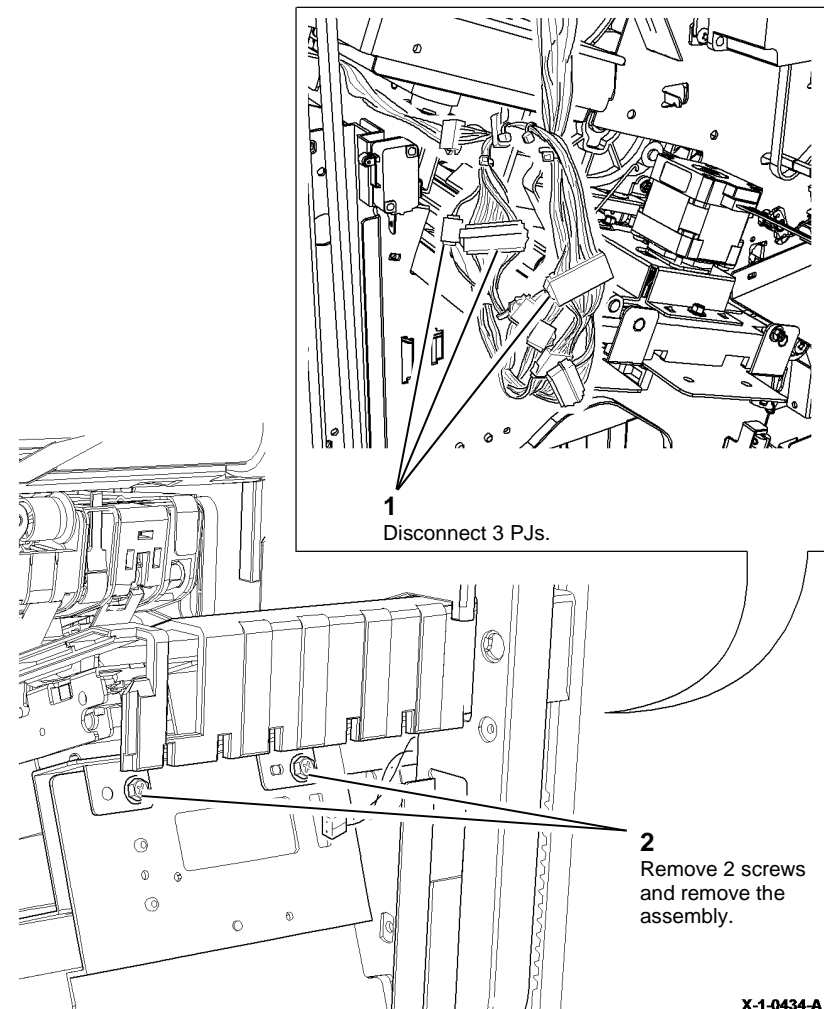
6. Remove the rear tamper assembly, [Figure 2](#).

1
Disconnect 3 PJs.

2
Remove 2 screws
and remove the
assembly.

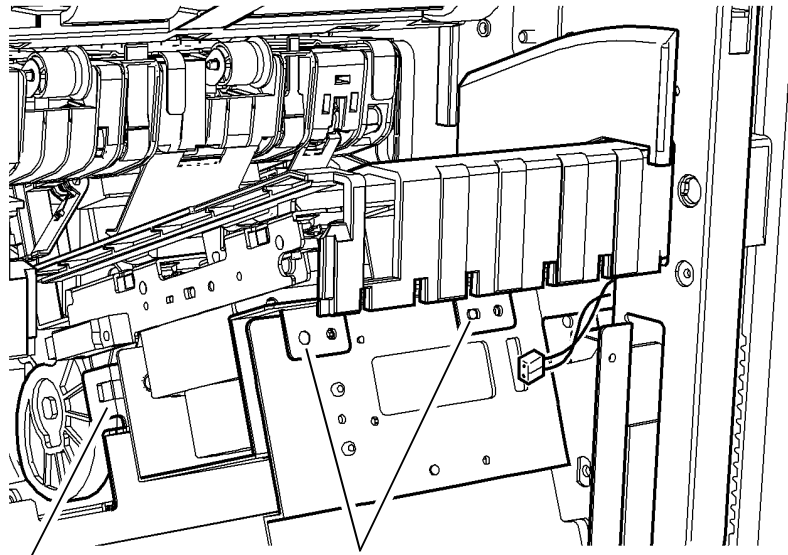
1. Reverse the removal procedures to reinstall the rear tamper assembly.
2. Ensure that the rear tamper assembly is located correctly, [Figure 3](#).

1
Ensure that the rear support pins are located correctly on the frame bracket.

2
Ensure that the fixing brackets are located on the tabs at the front.

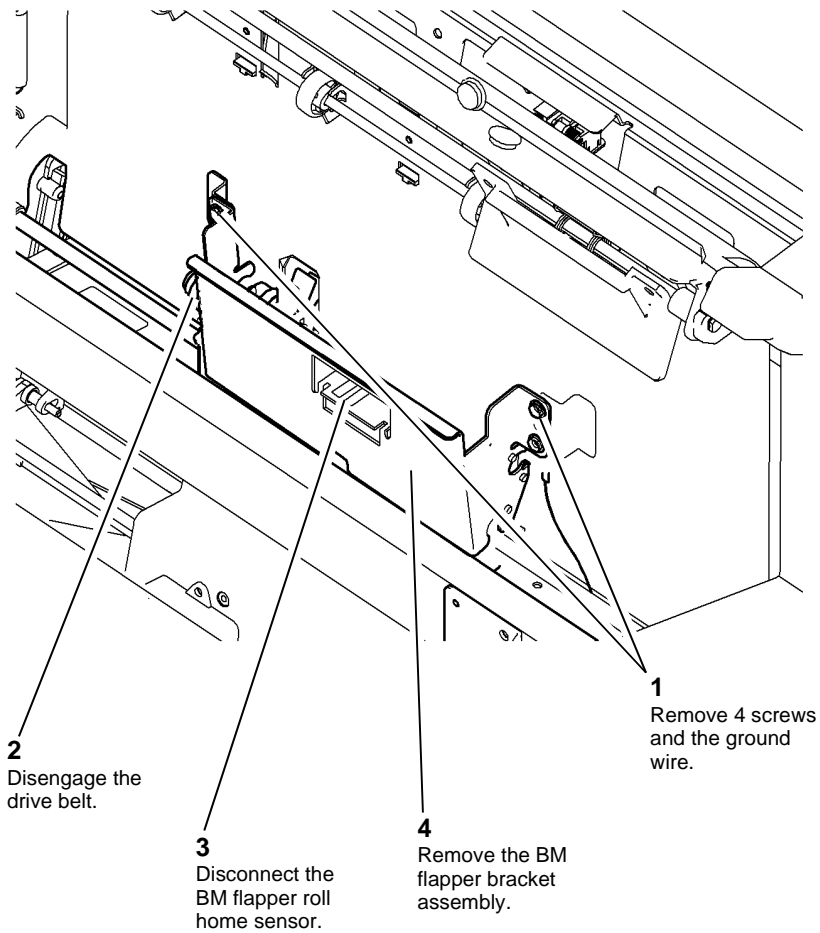
1. Open the HVF BM front door and fully pull out the BM module.
2. [Figure 1](#), remove the BM flapper bracket assembly.

2 Disengage the drive belt.

3 Disconnect the BM flapper roll home sensor.

Figure 1 BM flapper bracket removal
