708P91368
September 2017

Xerox® AltaLink® B8090 Family Multifunction Printer Service Manual

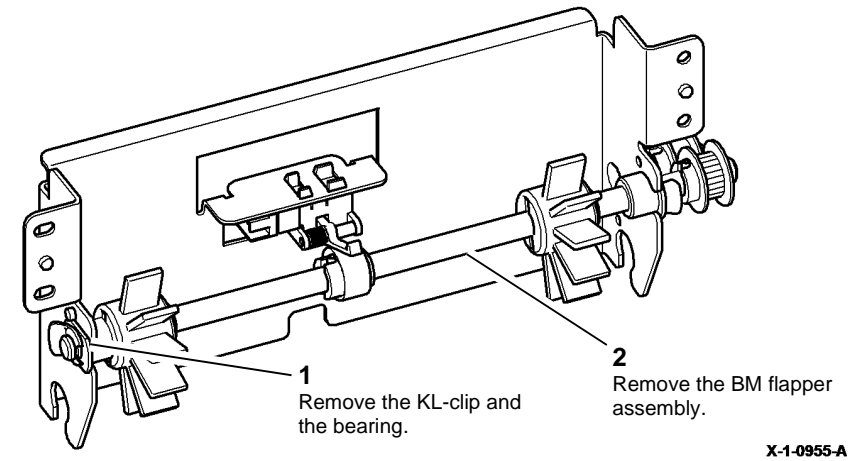
3. Figure 2, remove the BM flapper assembly.

1 Remove the KL-clip and the bearing.

2 Remove the BM flapper assembly.

Figure 2 BM flapper assembly removal

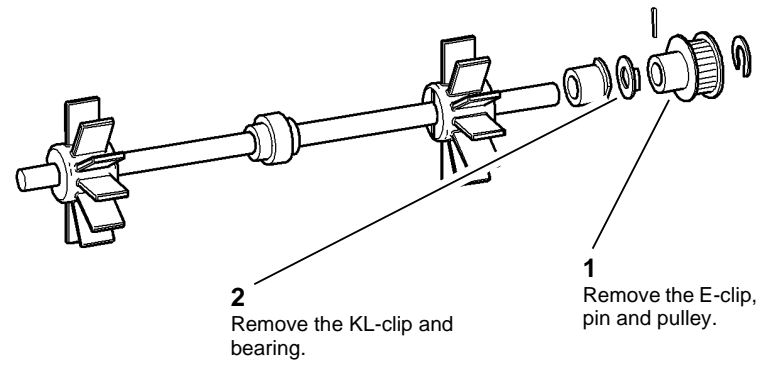
4. Figure 3, remove the BM flapper.

2 Remove the KL-clip and bearing.

1 Remove the E-clip, pin and pulley.

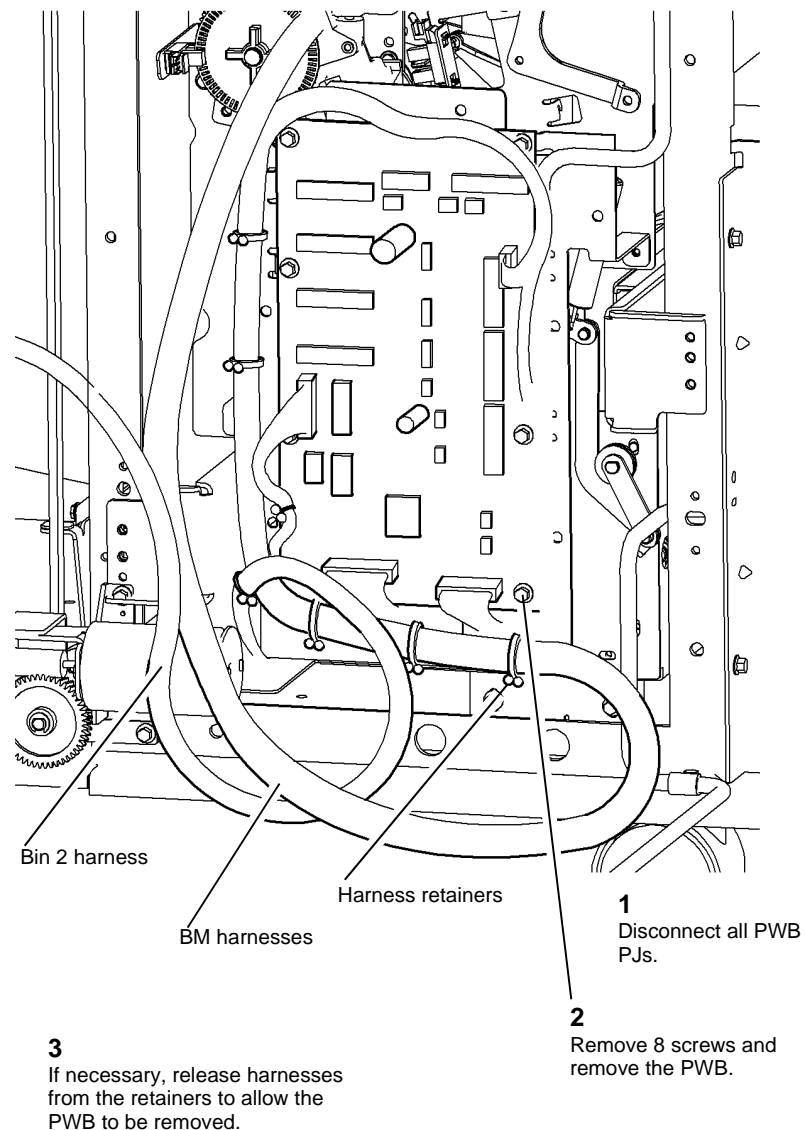
X-1-0439-A

2. [Figure 2](#), remove the BM PWB.

Figure 2 BM PWB removal

Figure 2, ensure the BM harness and bin 2 harness are correctly positioned in the retainers to prevent damaged when the BM is moved to the extremities of its travel.

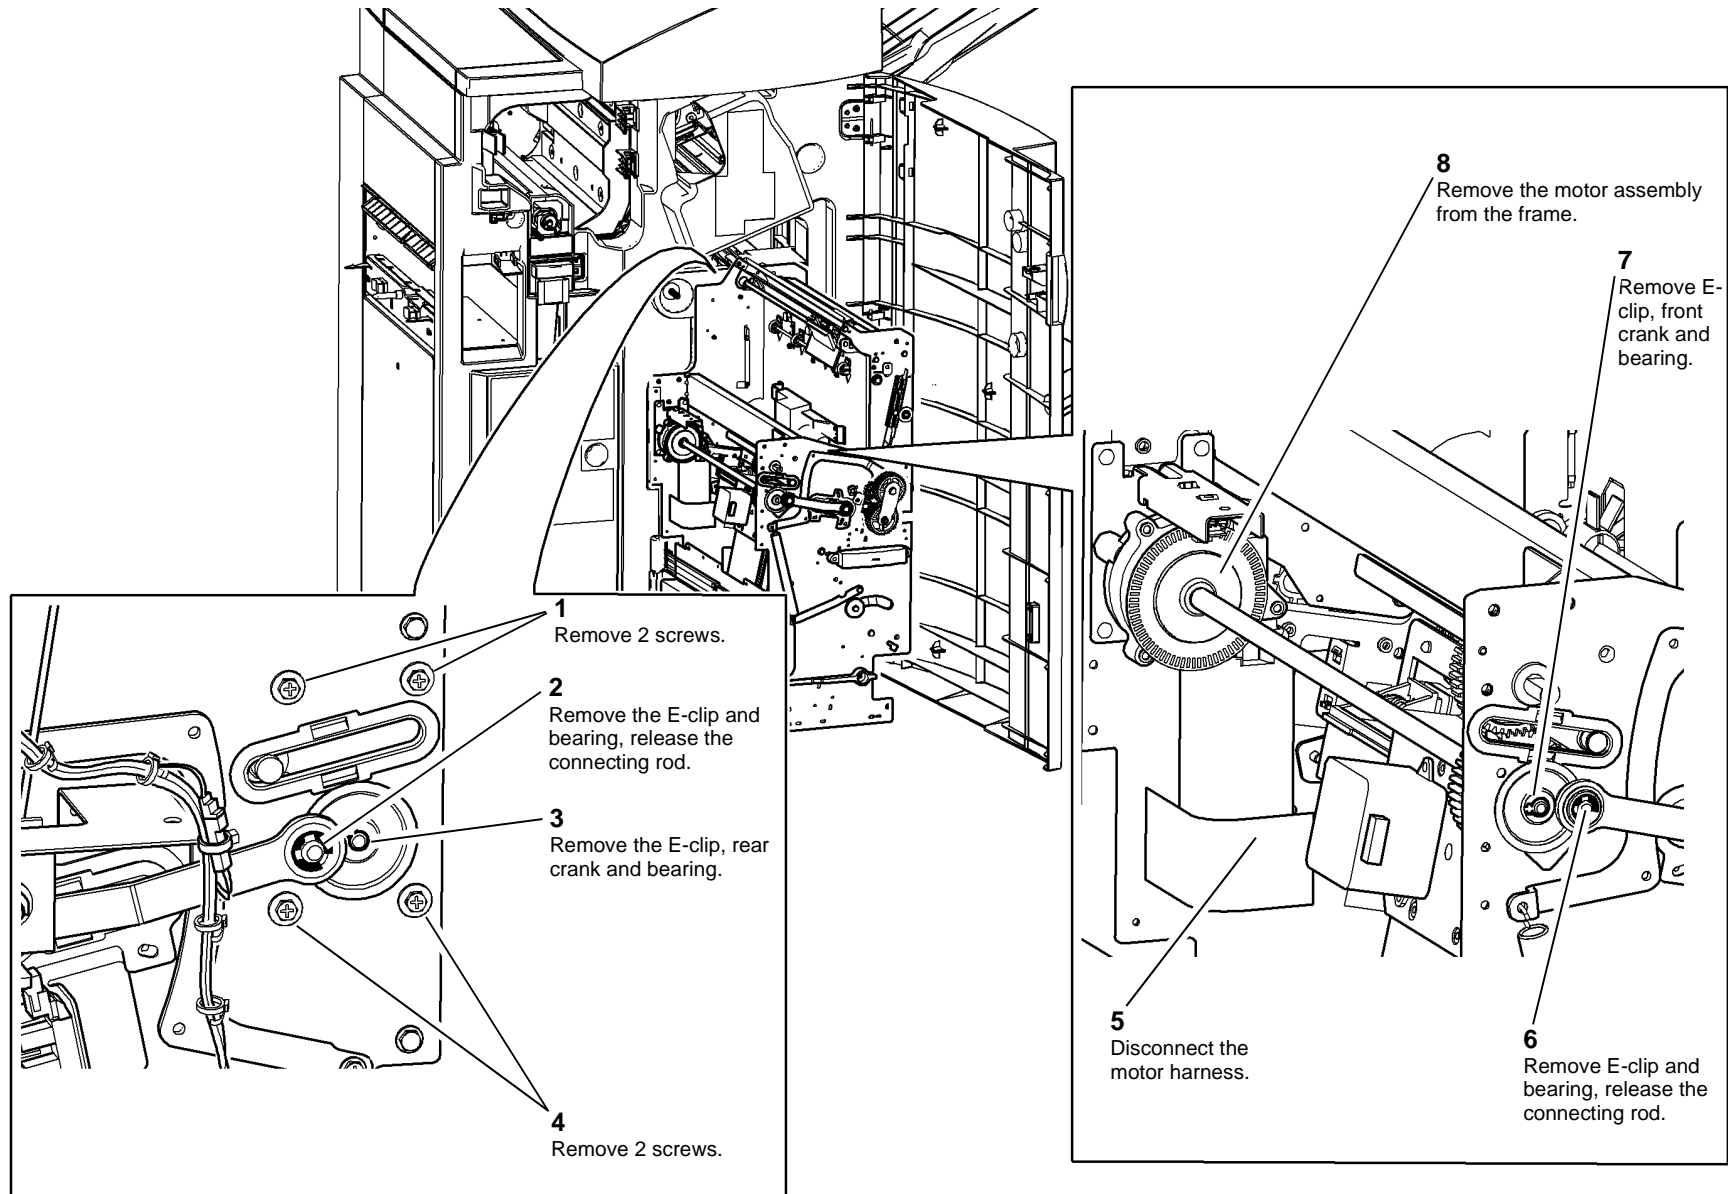
X-1-0440-A

7. Figure 1, remove the BM crease blade motor assembly.

Figure 1 Removing the motor assembly

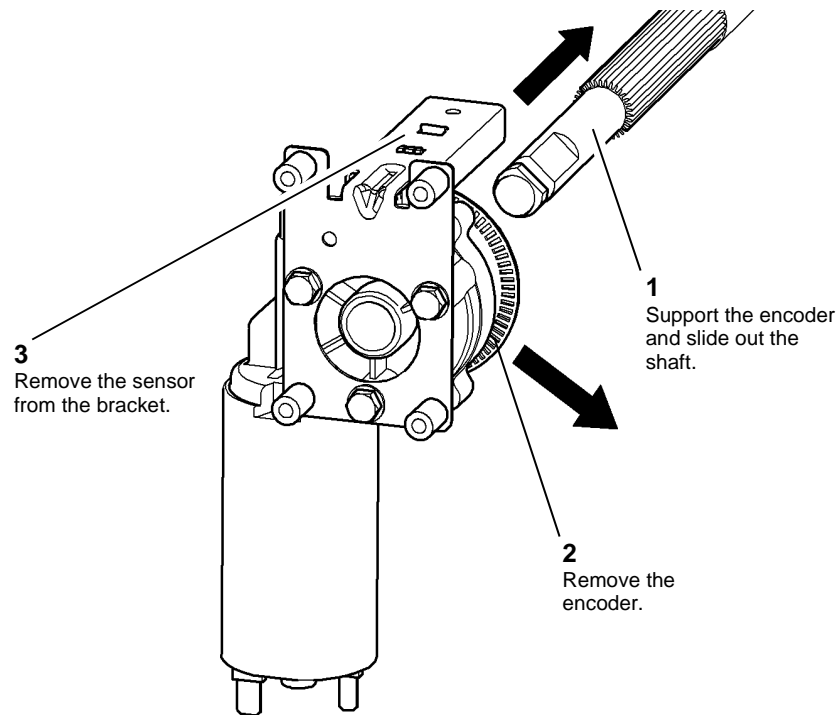
X-1-0441-A

8. [Figure 2](#), remove the BM crease blade motor.

Figure 2 Removing the motor

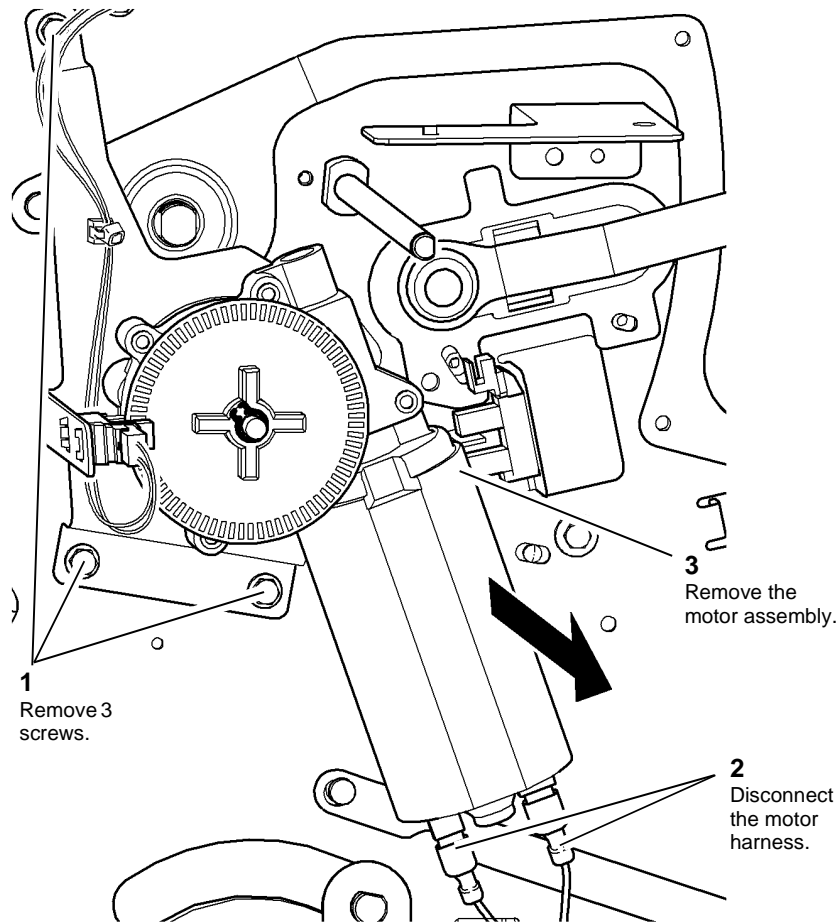
1 Remove 3 screws.

2 Disconnect the motor harness.

1. Remove the top cover, then the rear cover, [REP 12.1-171](#).
2. Remove 4 screws securing the BM PWB mounting plate to the frame, allow the PWB and mounting plate to hang down, giving access to the BM crease roll motor.

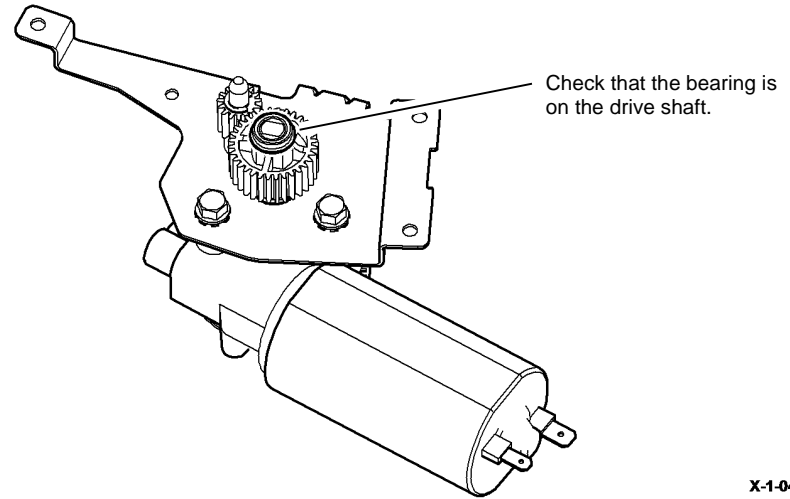
Figure 2 Location of bearing

1. Reverse the removal procedure to replace the BM crease roll motor.
2. Before installing the motor check the bearing, [Figure 2](#).

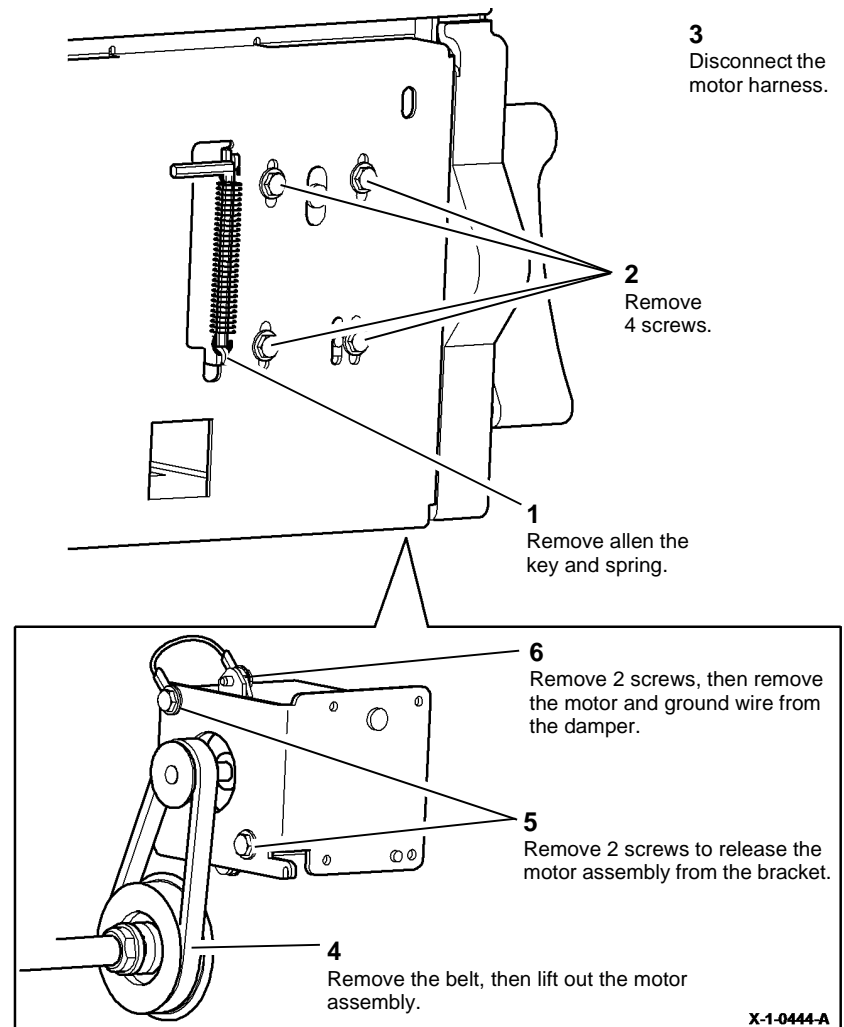
Figure 1 Motor removal

1. Open the HVF BM front door and fully pull out the BM module.
2. [Figure 1](#), remove the BM backstop motor.

NOTE: Allow the spring to tension the drive belt while the screws are still loose, then tighten the 4 screws.

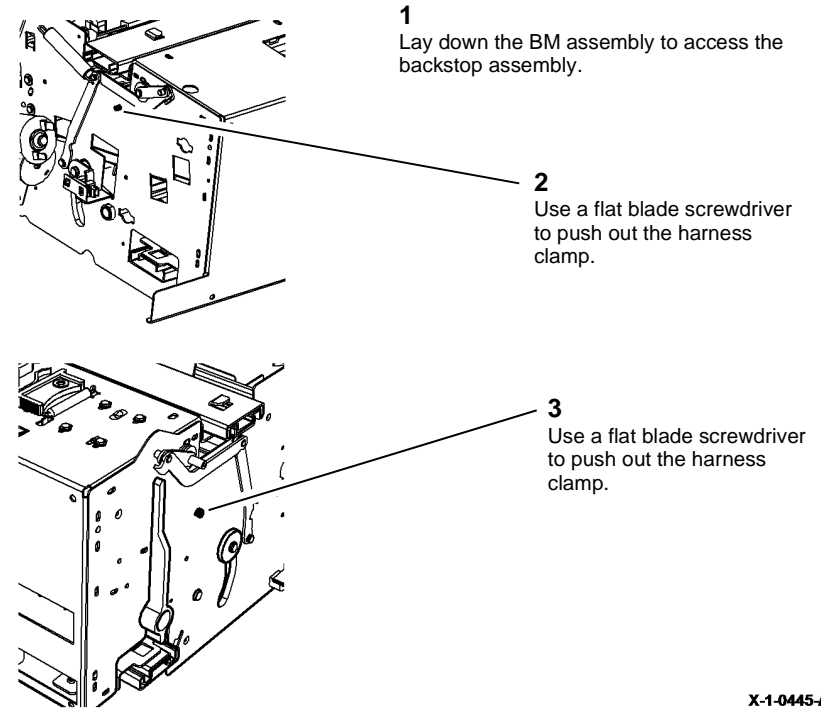
Figure 1 Harness clamps removal

6. Remove the two harness clamps, [Figure 1](#).

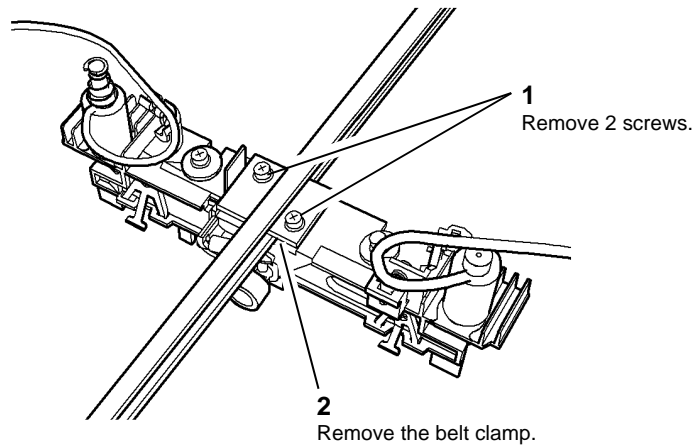
Figure 2 Belt clamp removal

- Remove the belt clamp, [Figure 2](#).

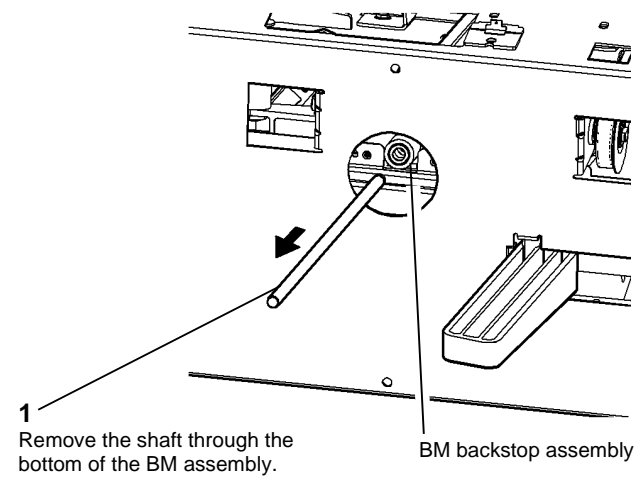
Figure 4 Remove the shaft

- Remove the shaft from the BM backstop assembly, [Figure 4](#).

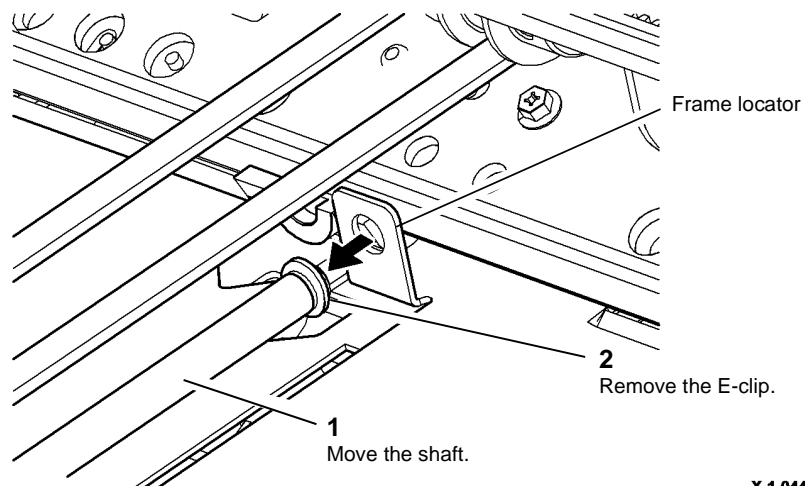
Figure 3 Preparation

- Use the allen key, [PL 12.160 Item 9](#) to remove the 2 screws and remove shaft support, [PL 12.165 Item 10](#).
- Prepare to remove the shaft from the frame, [Figure 3](#).

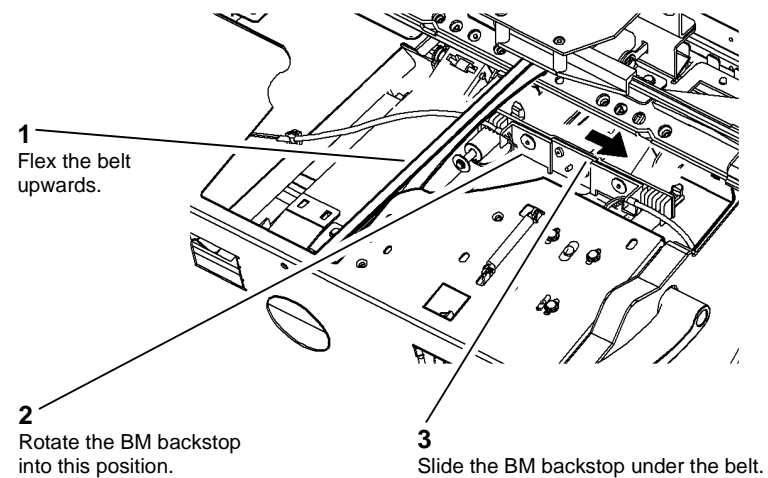
Figure 5 Backstop assembly removal

- Remove the BM backstop assembly, [Figure 5](#).

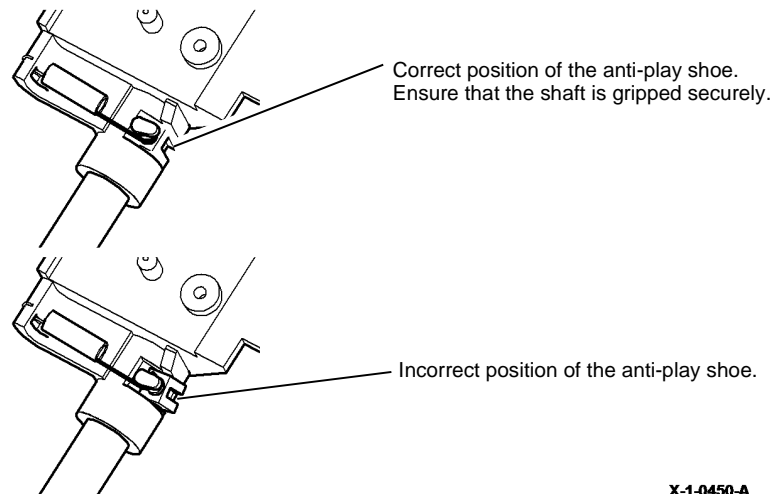
Figure 6 Anti-play shoe location

1. Reverse the removal procedure to replace the backstop assembly.
2. When installing the shaft ensure that the anti-play shoe has not moved out of position, [Figure 6](#).

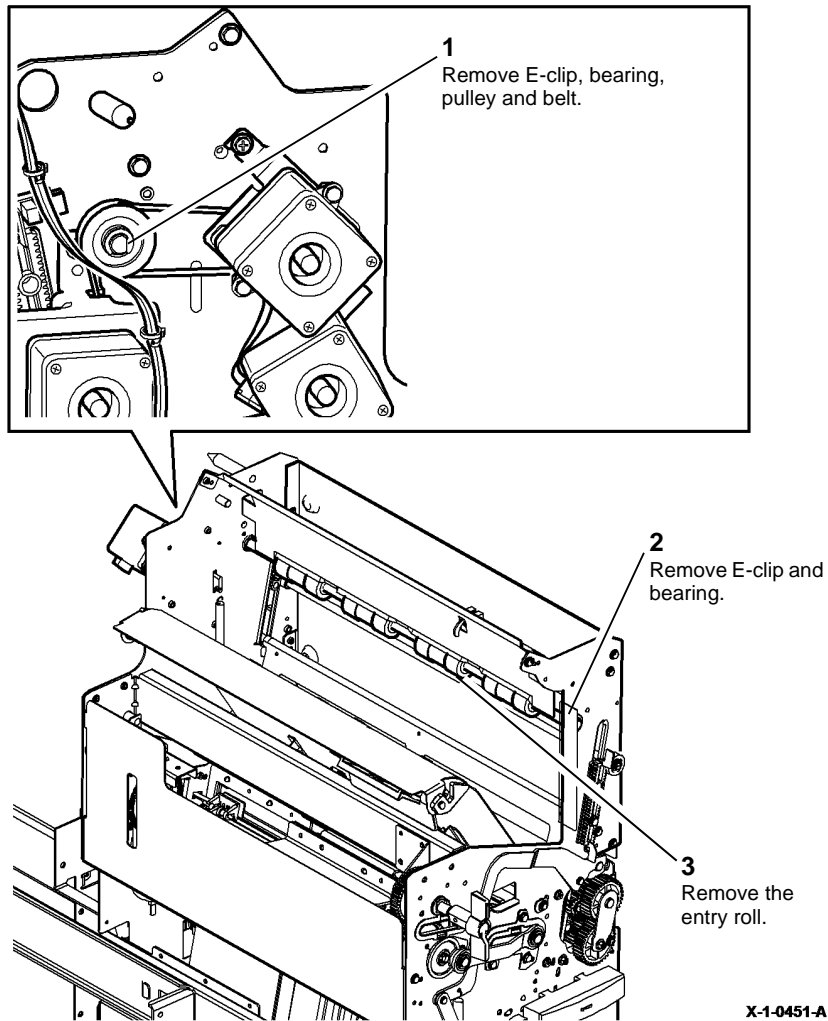
Figure 1 BM entry roll removal

5. Figure 1, remove the BM Entry Roll.

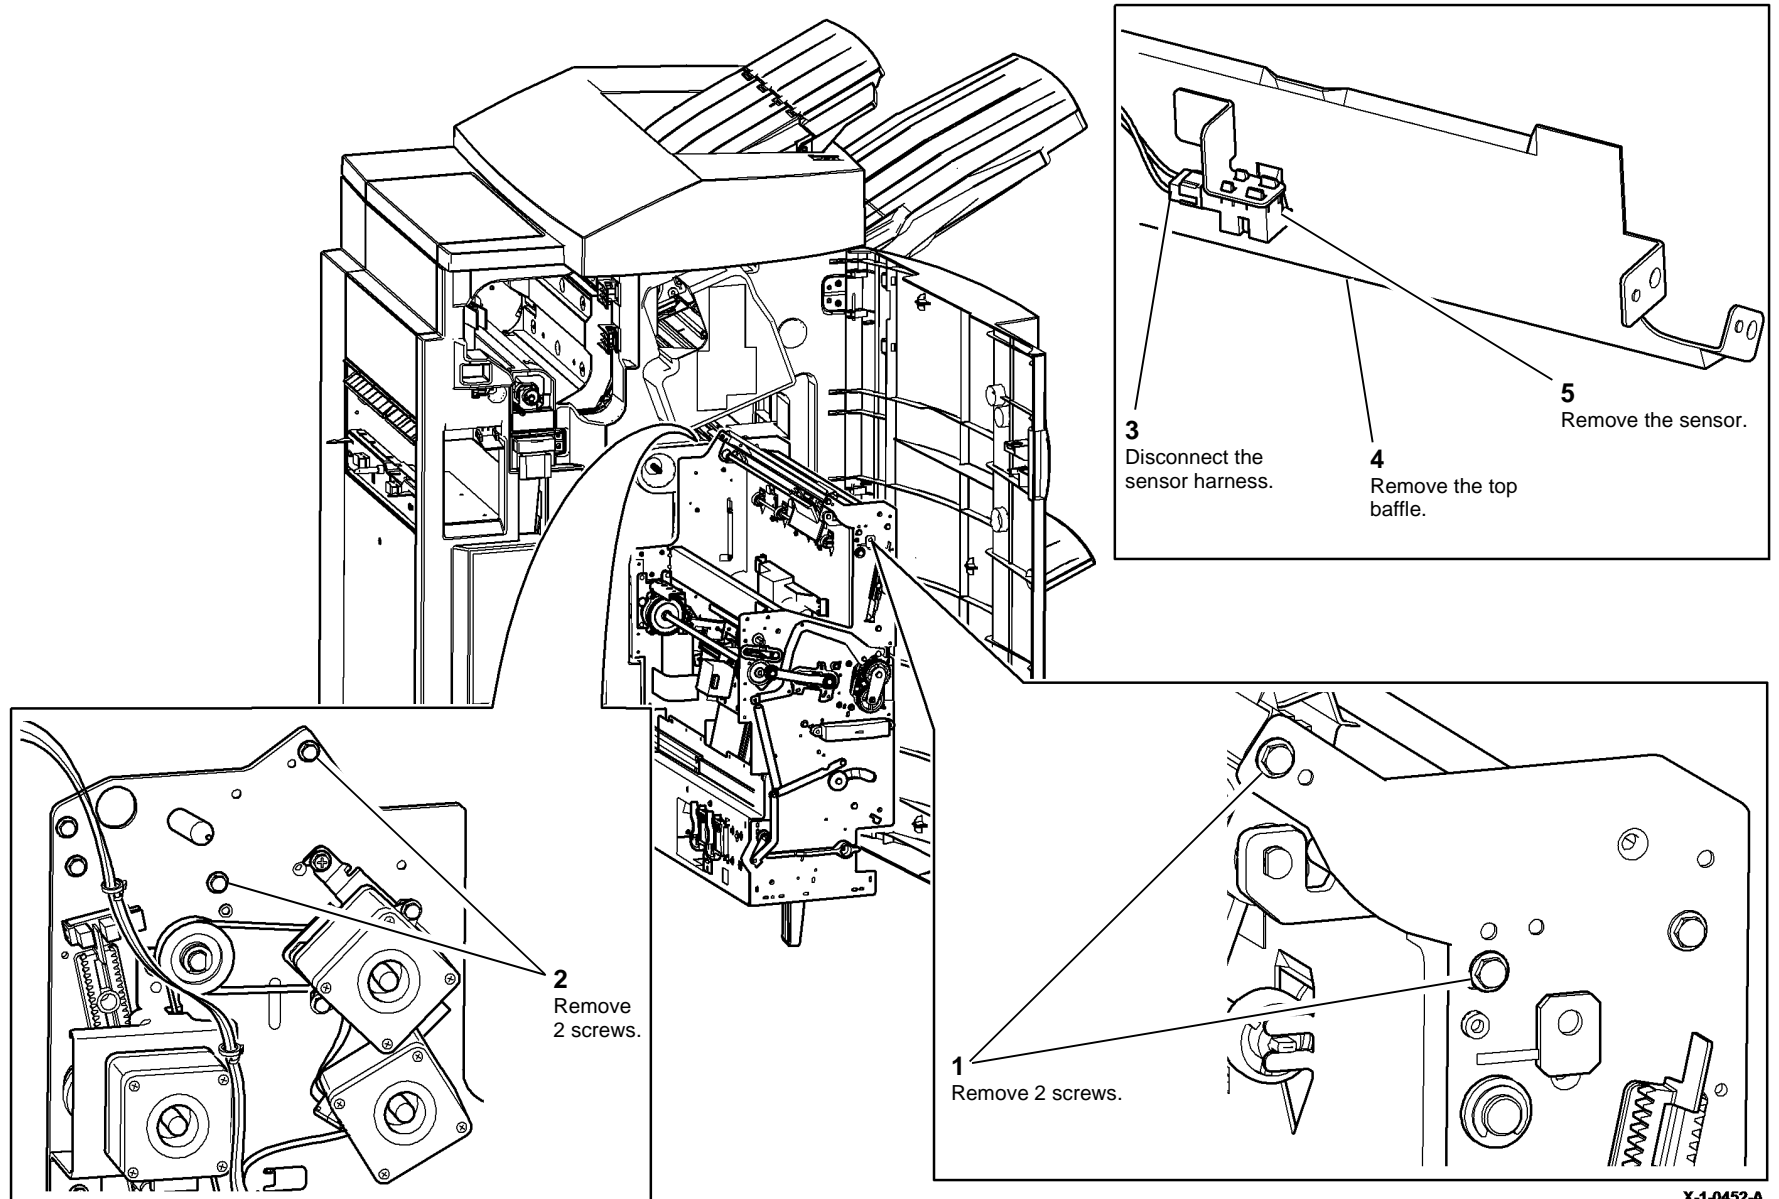
Figure 1 Sensor removal

5. Figure 1, remove the BM entry sensor.

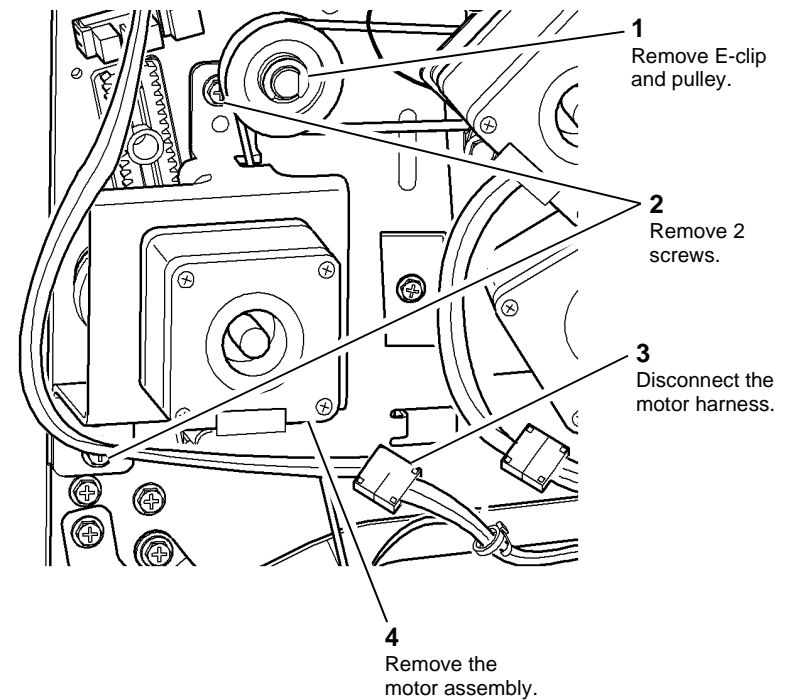
Figure 1 Motor assembly removal

1. Remove the rear cover, [REP 12.1-171](#).
2. [Figure 1](#), remove the motor assembly

3. Remove 3 nuts to release the motor from the bracket.
- Reverse the removal procedure to replace the BM crease roll gate motor.

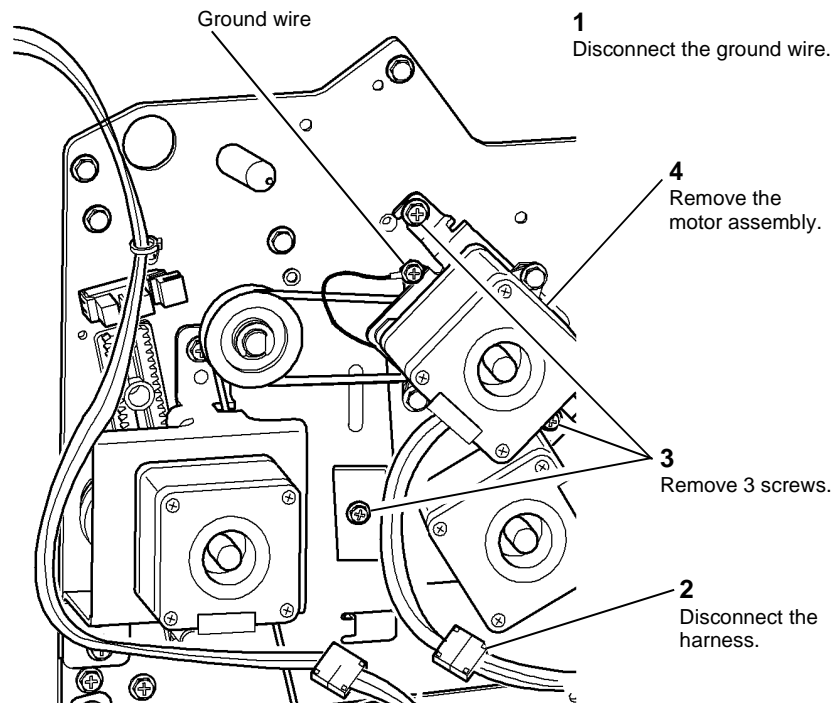
Figure 1 Motor assembly removal

1. Remove the rear cover, [REP 12.1-171](#).
2. [Figure 1](#), remove the motor assembly.

3. Remove 2 screws to remove the relevant motor from the bracket.
4. Remove 2 screws to remove the motor from the damper.

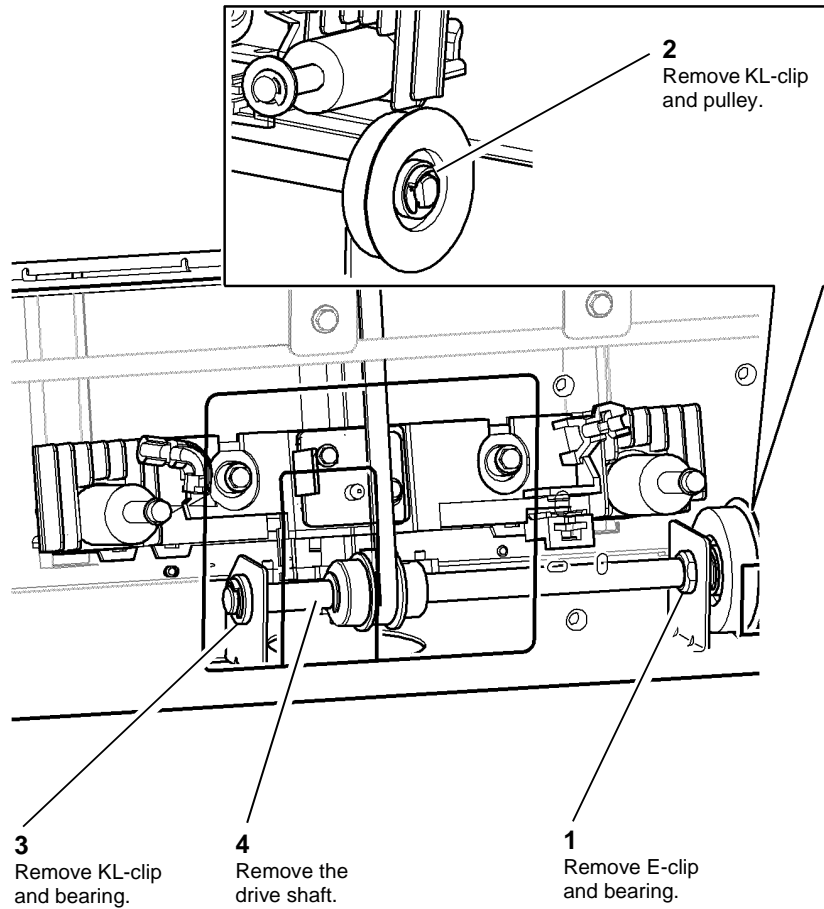
Figure 1 Drive shaft removal

10. **Figure 1**, remove the BM backstop drive shaft and bearings.

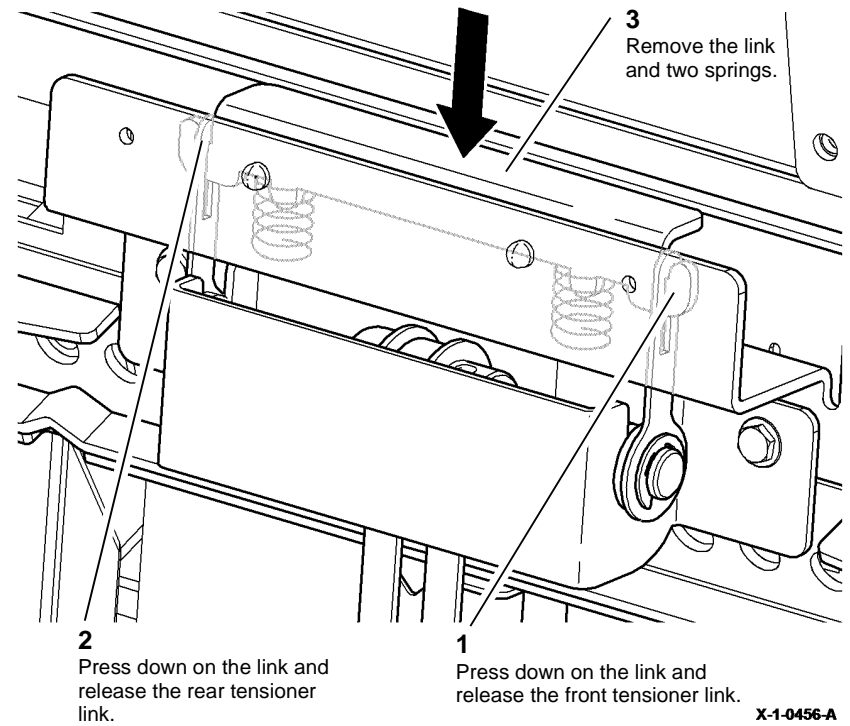
Figure 2 Backstop link removal

11. **Figure 2**, remove the backstop link.

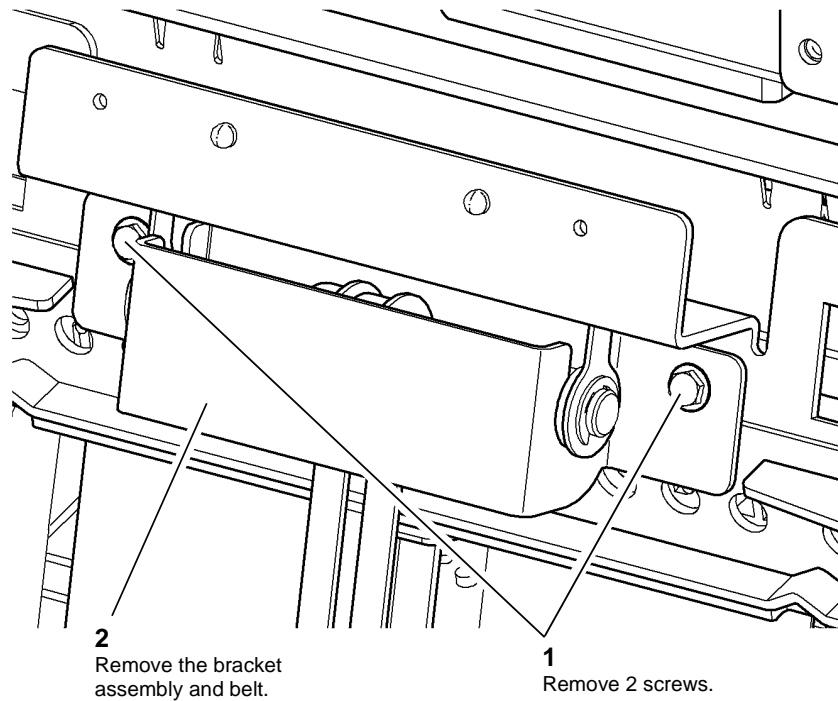
Figure 3 Bracket assembly removal

12. Figure 3, remove the BM backstop idler bracket assembly.

Reverse the removal procedure to replace the removed components. Allow the BM backstop belt to be tensioned correctly before the bracket assembly securing screws are tightened. Refer to Figure 3.

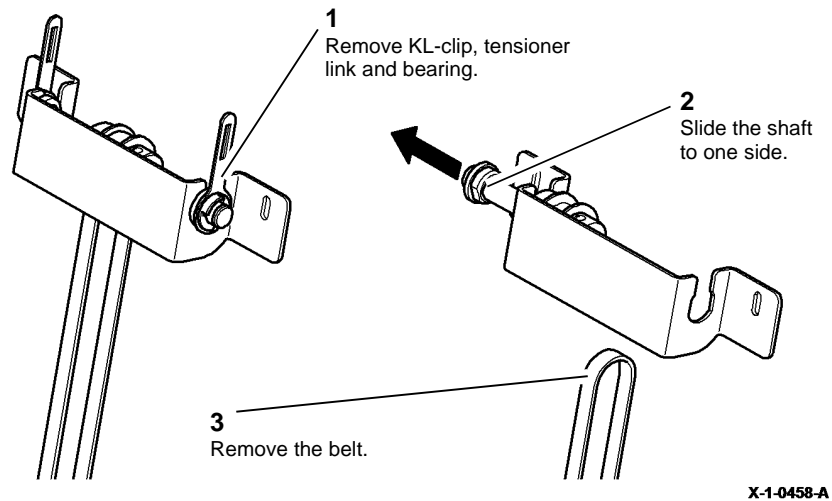
Figure 4 Backstop belt removal

13. Figure 4, remove the BM backstop belt.

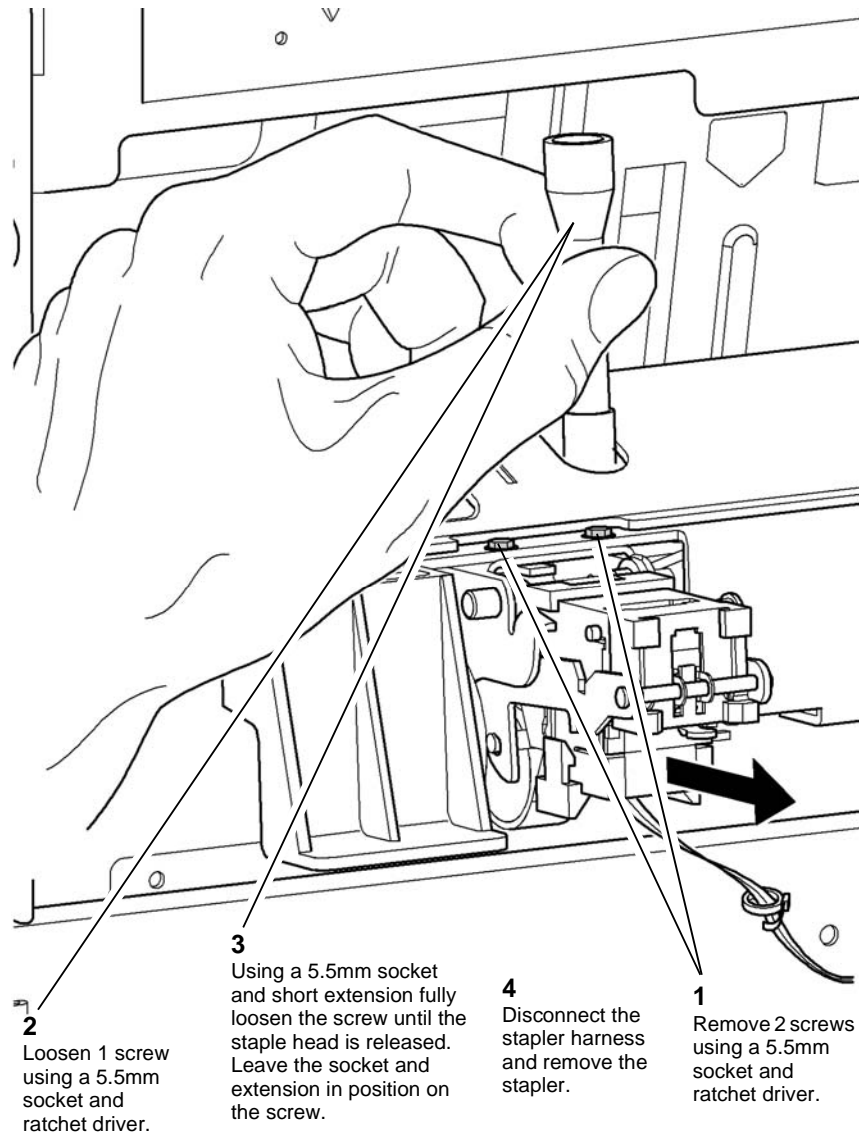
Figure 1 Staple head removal

4. **Figure 1**, remove the relevant staple head.

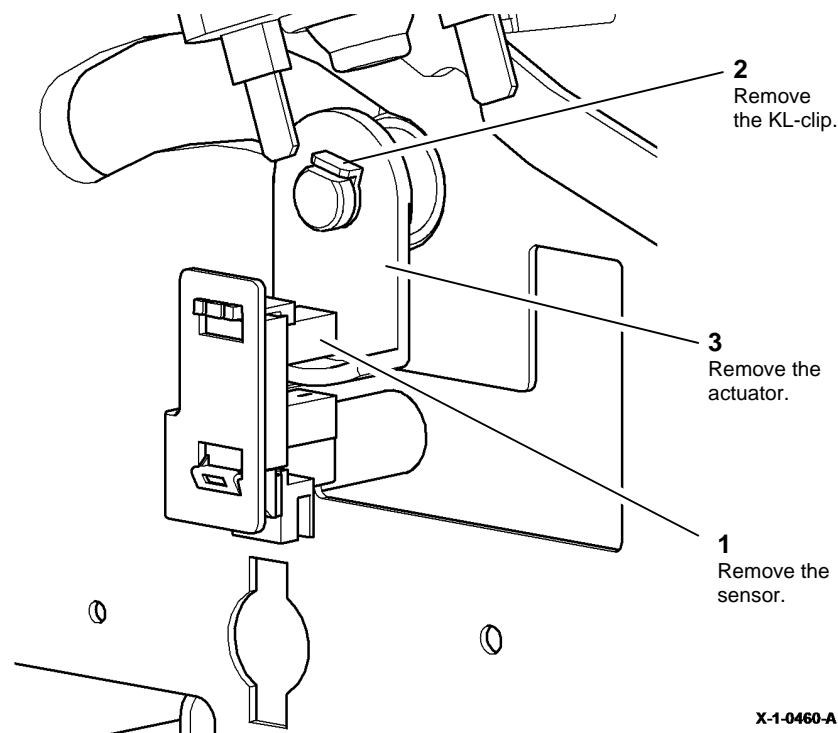
Figure 1 Actuator removal

3. [Figure 1](#), remove the BM staple head carrier closed sensor actuator.

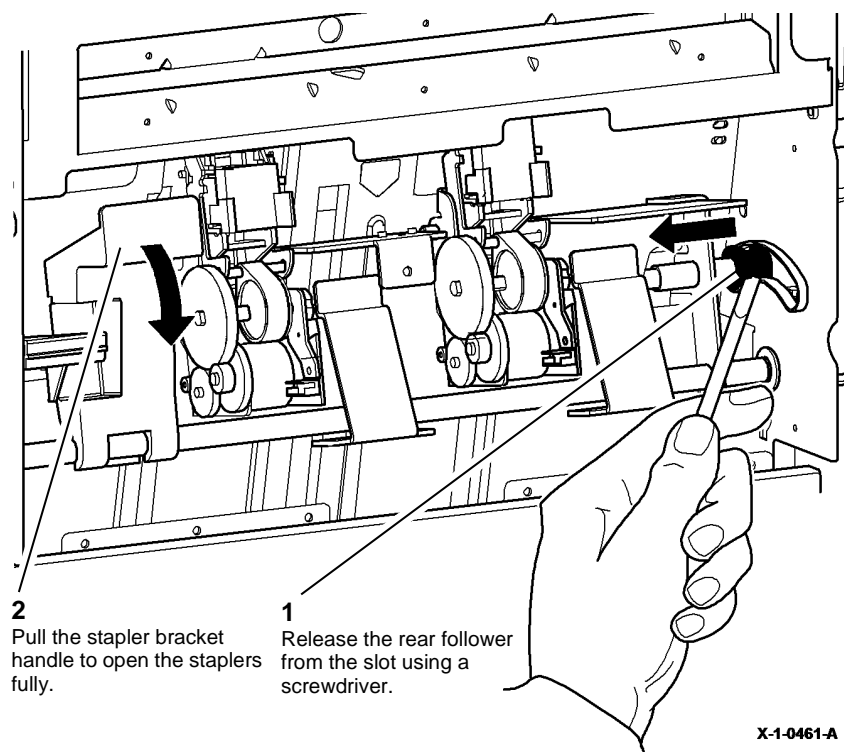
Figure 2 Stapler bracket lowering

10. **Figure 2**, lower the stapler bracket.

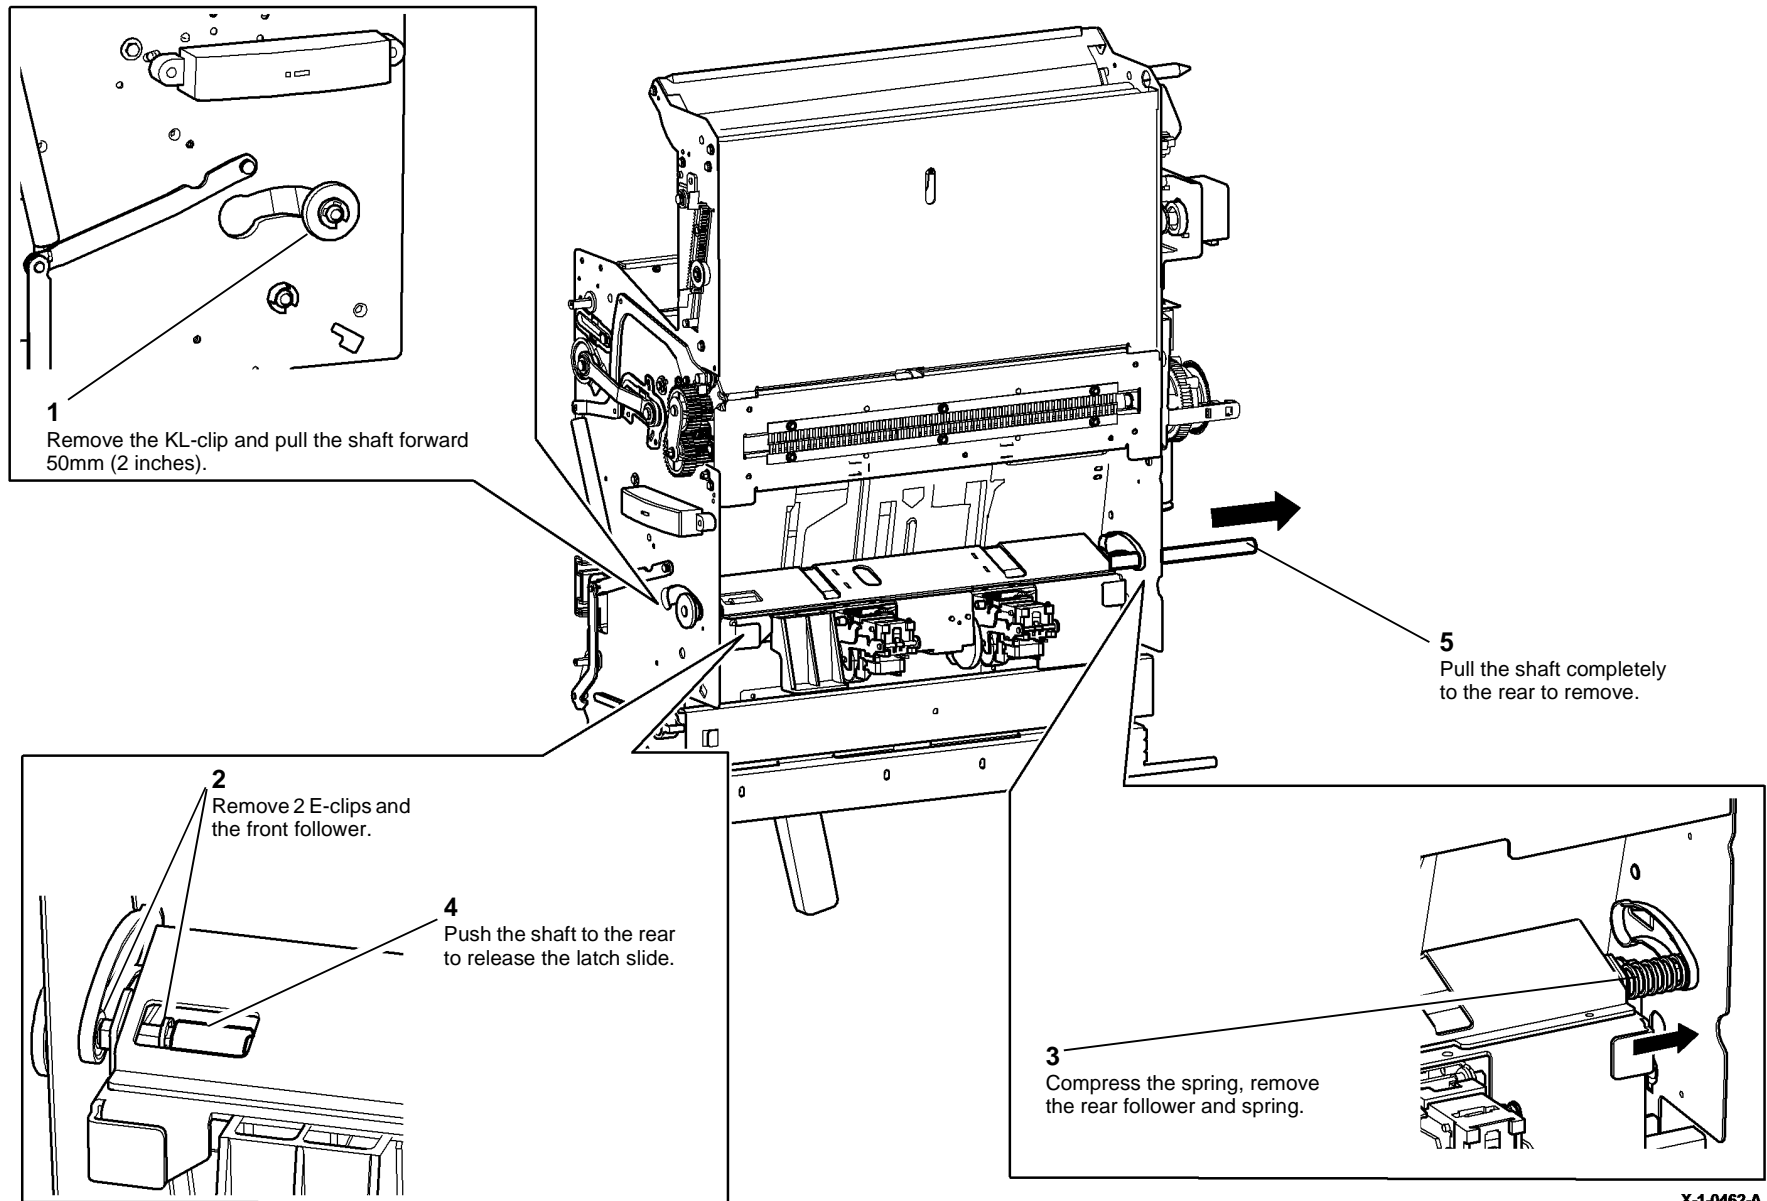
Figure 3 Latch shaft removal

11. Figure 3, remove the latch shaft.

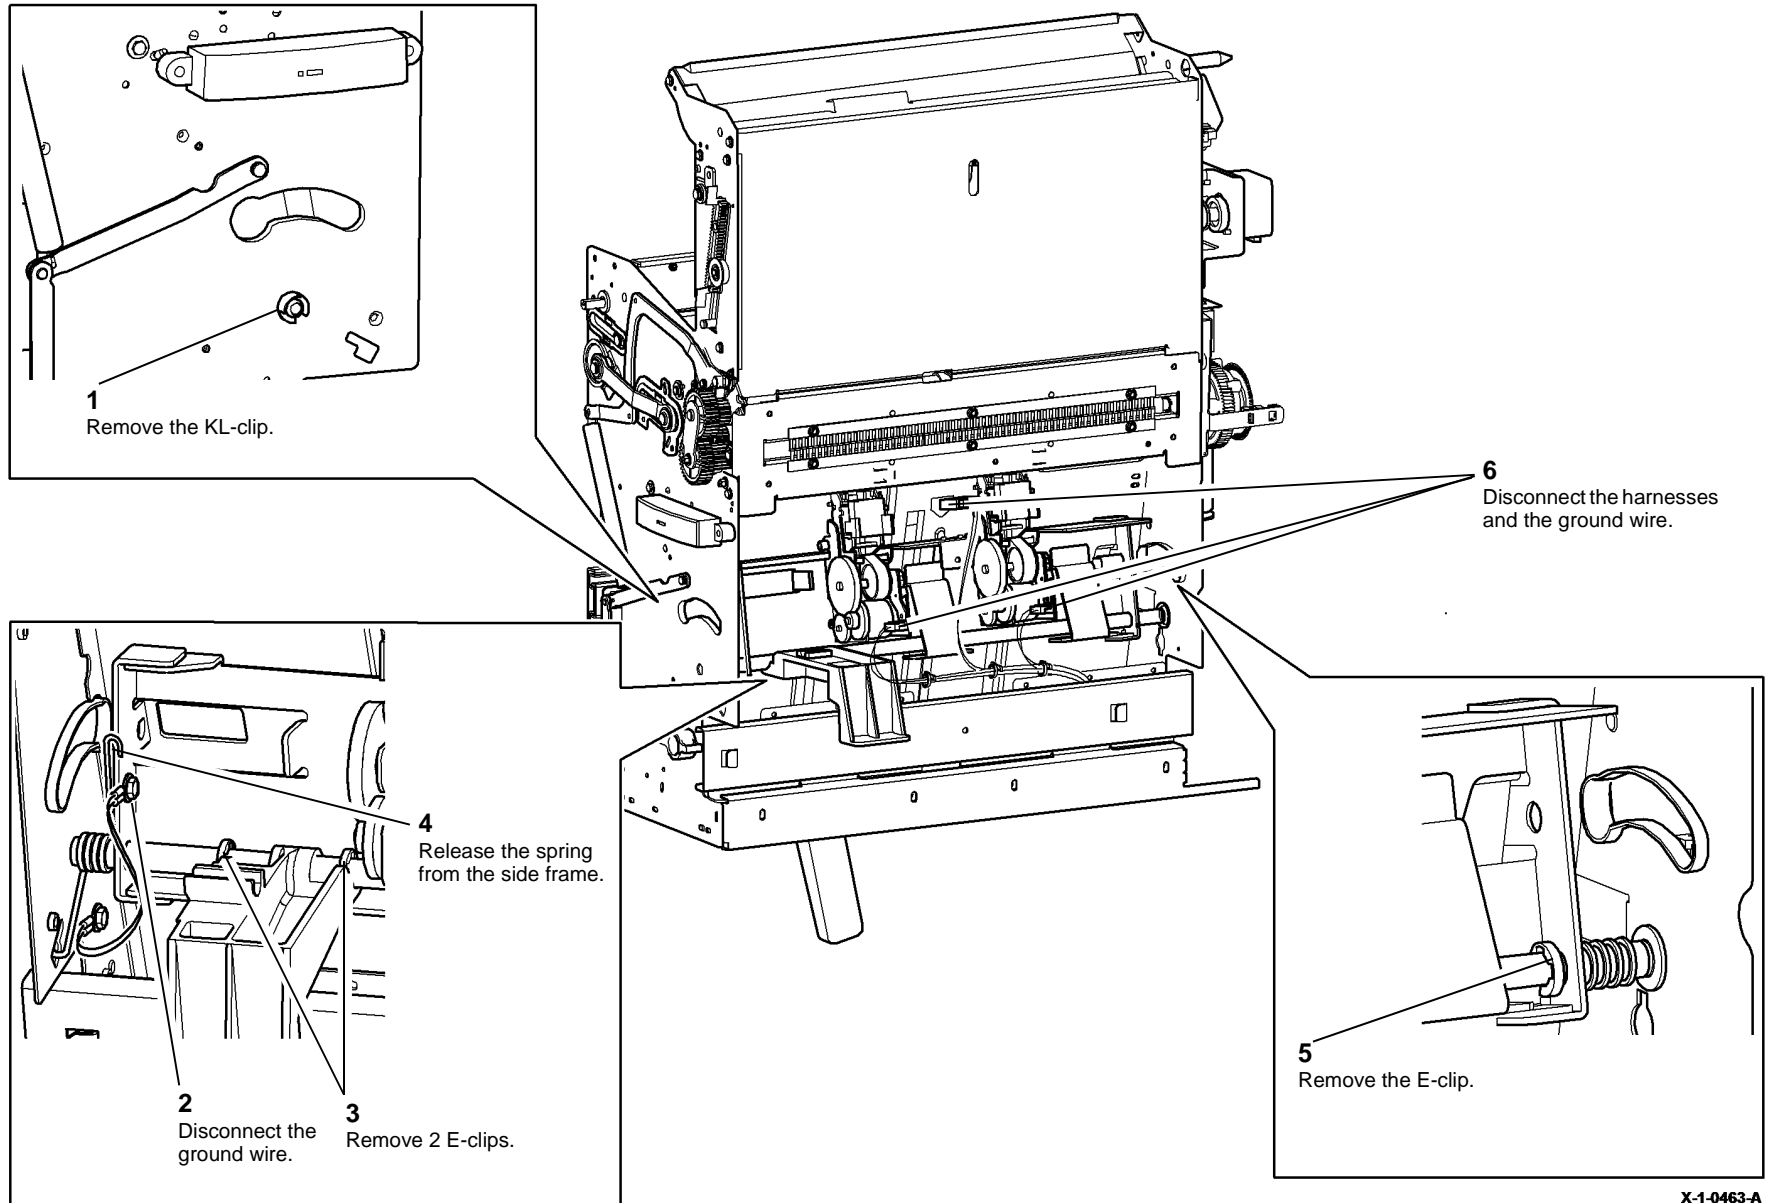
Figure 4 Preparation

12. Figure 4, prepare to remove the BM stapler bracket assembly.

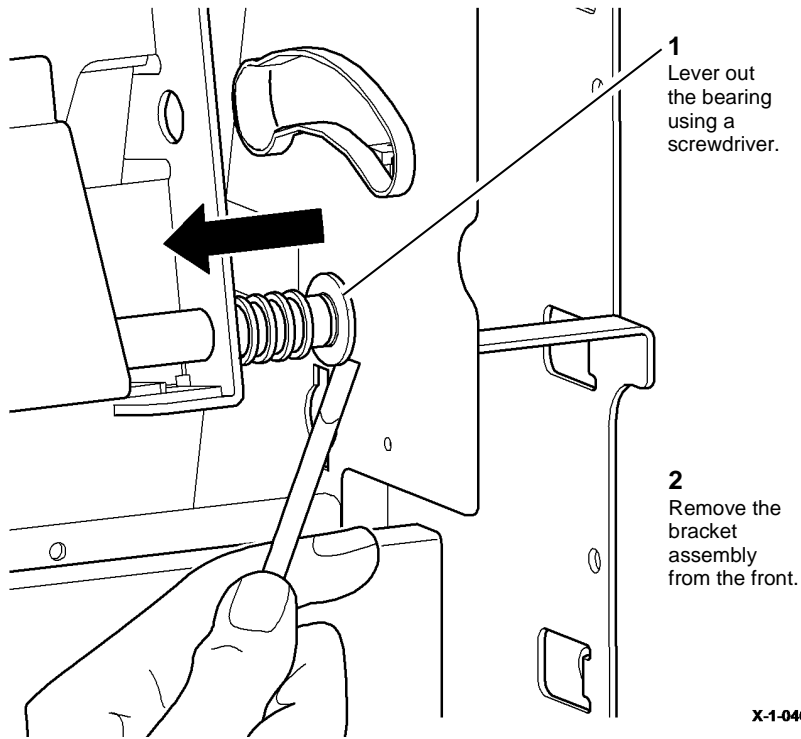
Figure 5 Assembly removal

13. Figure 5, remove the BM stapler bracket assembly.
