708P91368
September 2017

Xerox® AltaLink® B8090 Family Multifunction Printer Service Manual

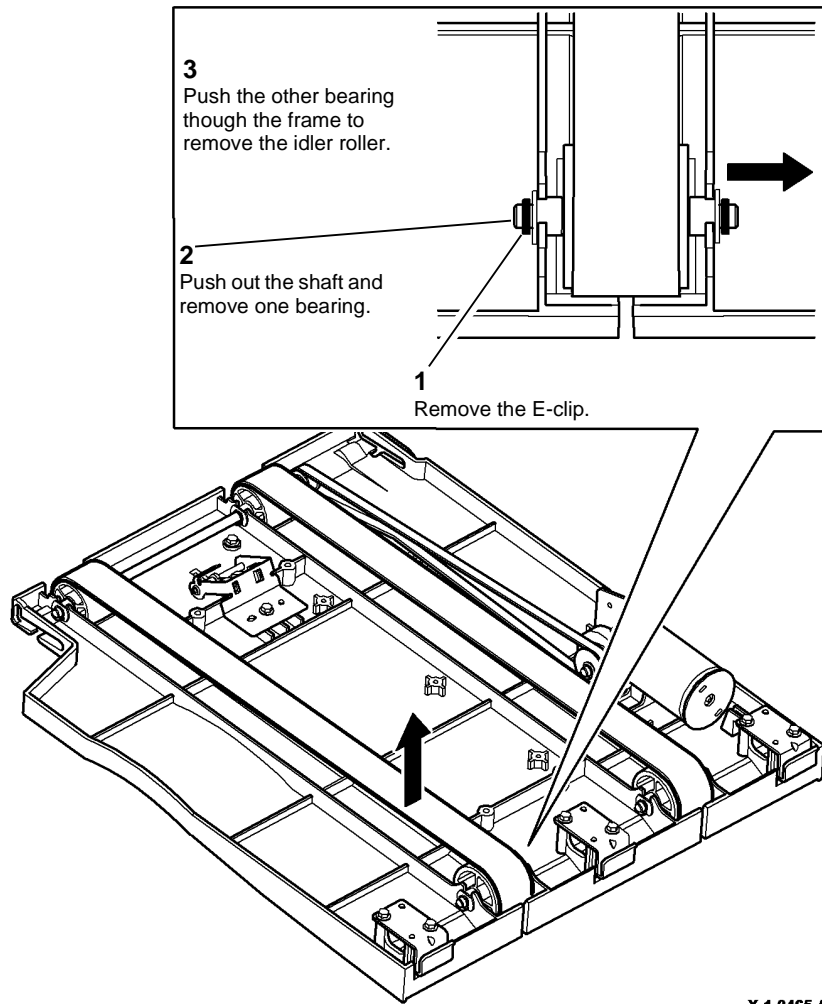
Figure 1 Idler roller removal

5. **Figure 1**, remove the idler roller.

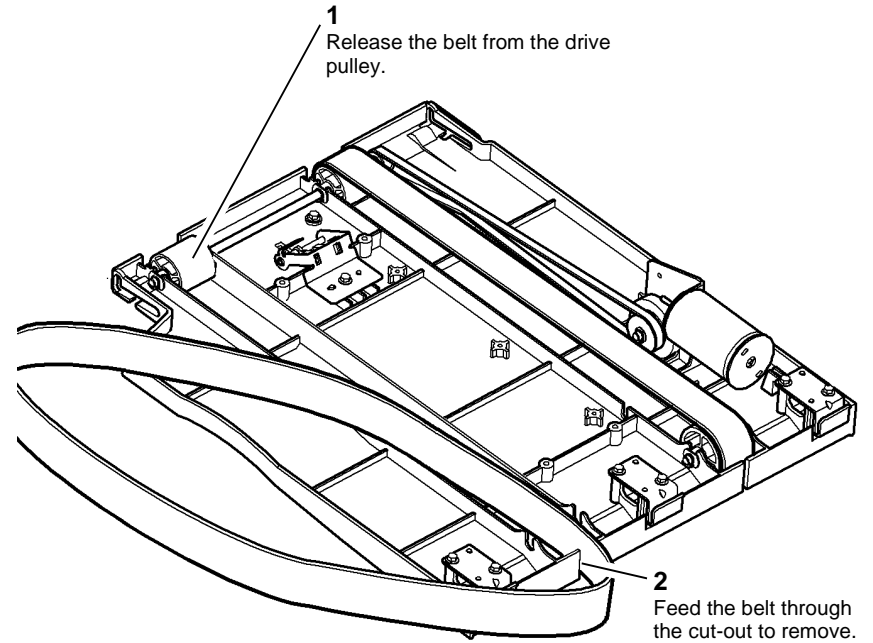
Figure 2 Belt removal

6. **Figure 2**, remove the BM conveyor belt.

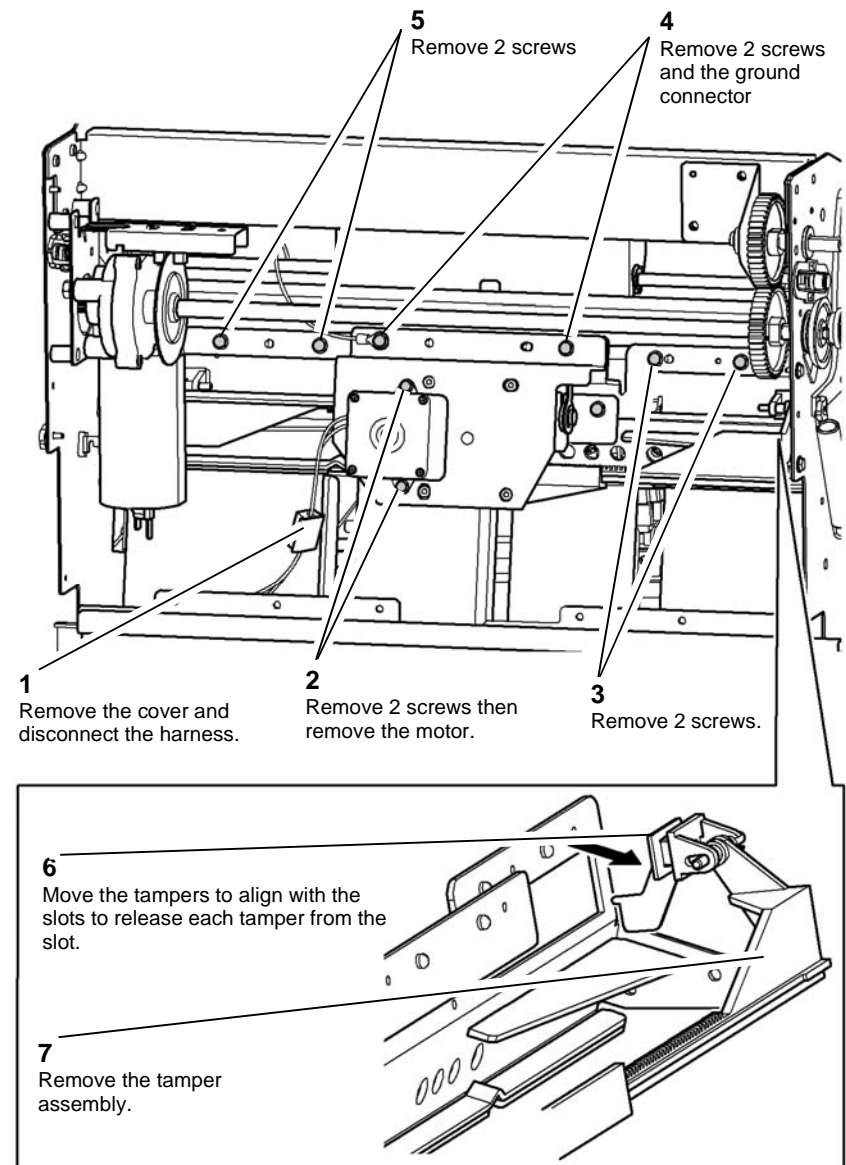
Figure 1 Tamper assembly removal

6. [Figure 1](#), remove the tamper assembly.

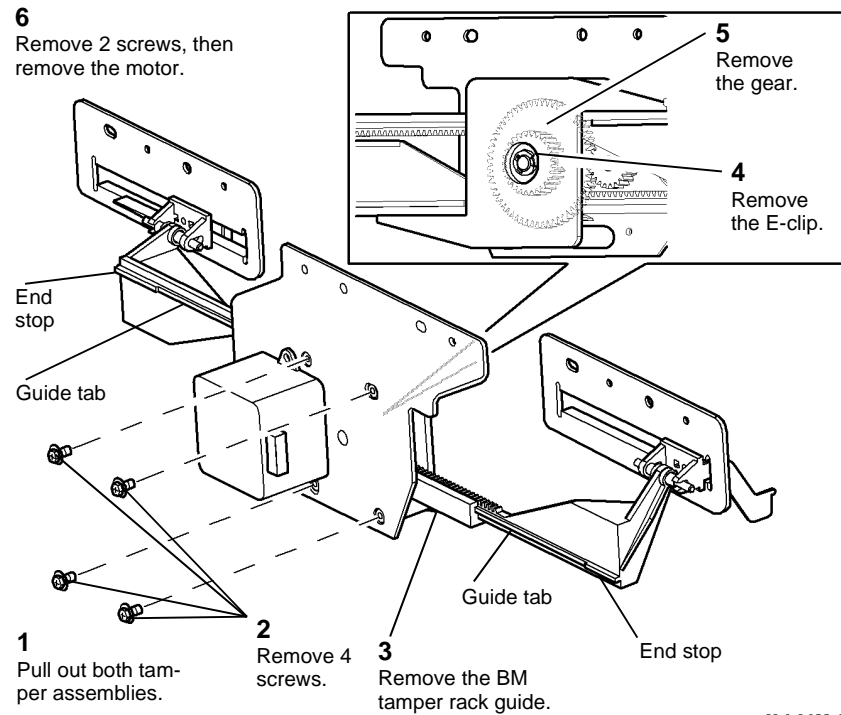
Figure 2 Dismantling the assembly

7. **Figure 2**, remove the front and rear tamper assemblies. Also remove the tamper gear and tamper motor.

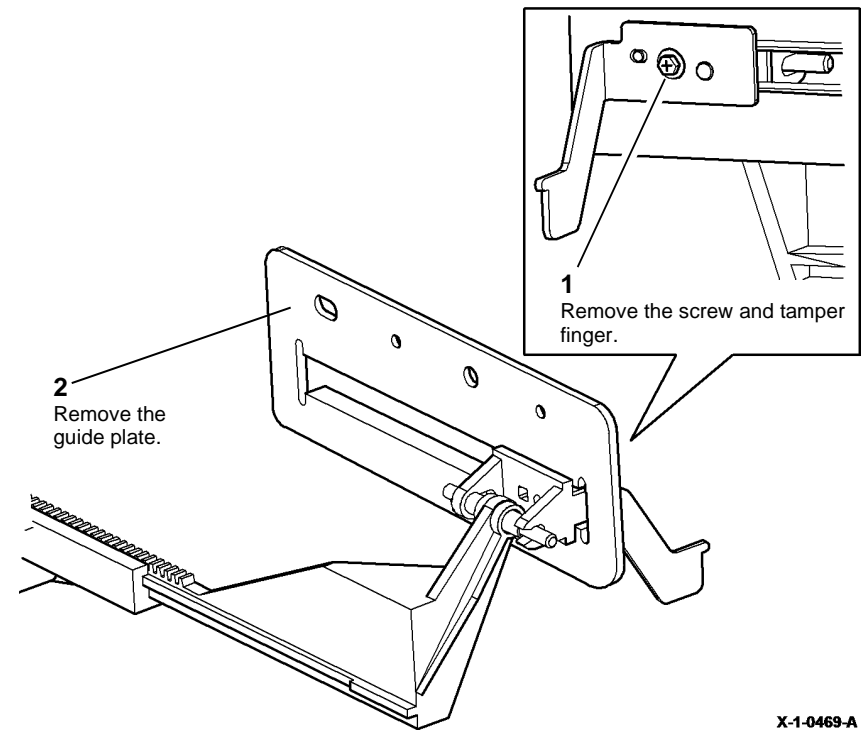
Figure 3 Guide plate removal

8. **Figure 3**, remove the tamper guide plate from each of the tamper assemblies.

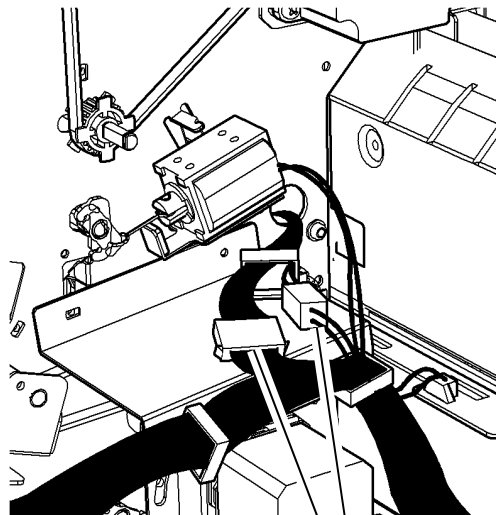
REAR VIEW

- 1 Disconnect two PJs.

Figure 1 Preparation

1. Remove the HVF front door, [REP 12.1-171](#).
2. Remove the HVF top cover, [REP 12.1-171](#).
3. Remove the HVF front cover, [REP 12.1-171](#).
4. Remove the HVF rear cover, [REP 12.1-171](#).
5. [Figure 1](#). Prepare to remove the guide assembly.

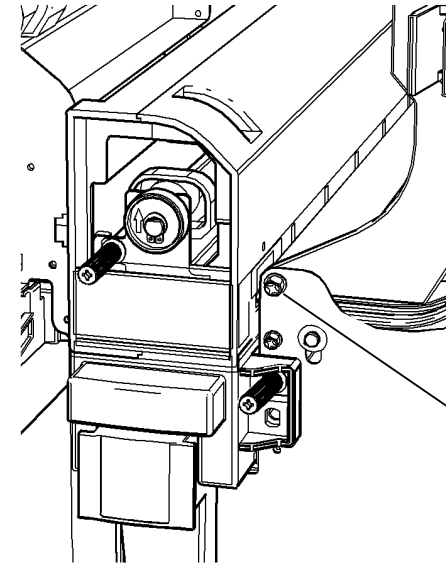
- 3 Withdraw the guide through the front opening.

- 2 Pass the PJs through the cut-out in the rear frame

6. [Figure 2](#). Remove the buffer guide assembly.

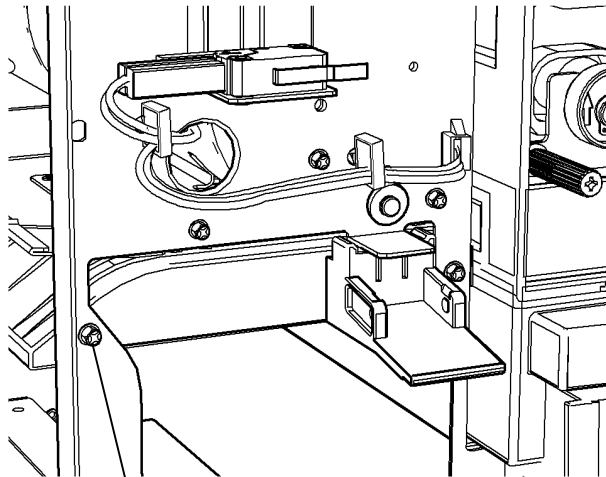
1
Remove the
pivot screw

2
Remove the guide through
the front opening

1. Remove the HVF front door, [REP 12.1-171](#).
2. Remove the HVF top cover, [REP 12.1-171](#).
3. Remove the HVF front cover, [REP 12.1-171](#).
4. [Figure 1](#). Remove the input jam clearance guide.

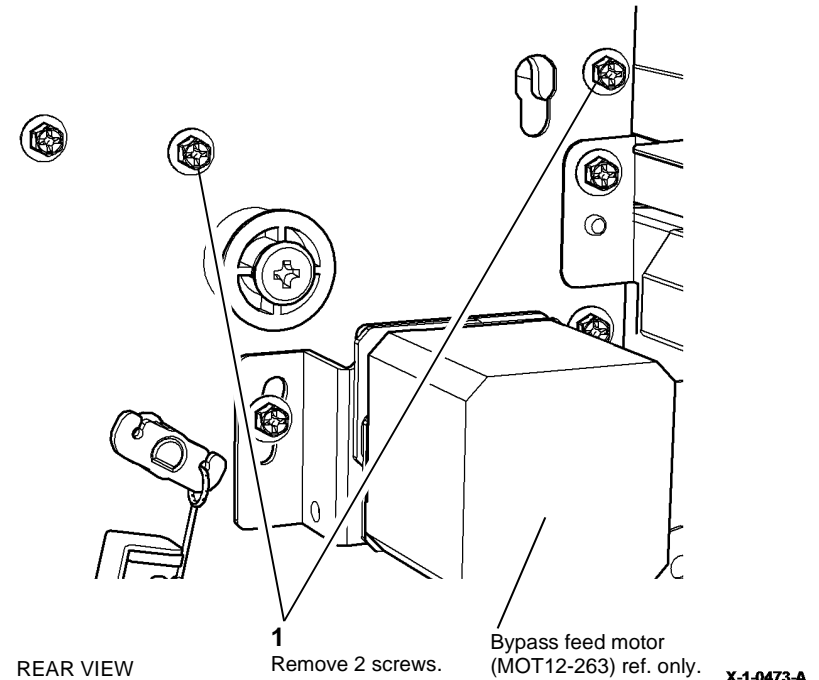
Figure 1 Preparation

1. Remove the HVF front door, [REP 12.1-171](#).
2. Remove the HVF top cover, [REP 12.1-171](#).
3. Remove the HVF front cover, [REP 12.1-171](#).
4. Remove the HVF rear cover, [REP 12.1-171](#).
5. Remove the buffer pocket roll, [REP 12.42-171](#).
6. [Figure 1](#). Prepare to remove the guide.

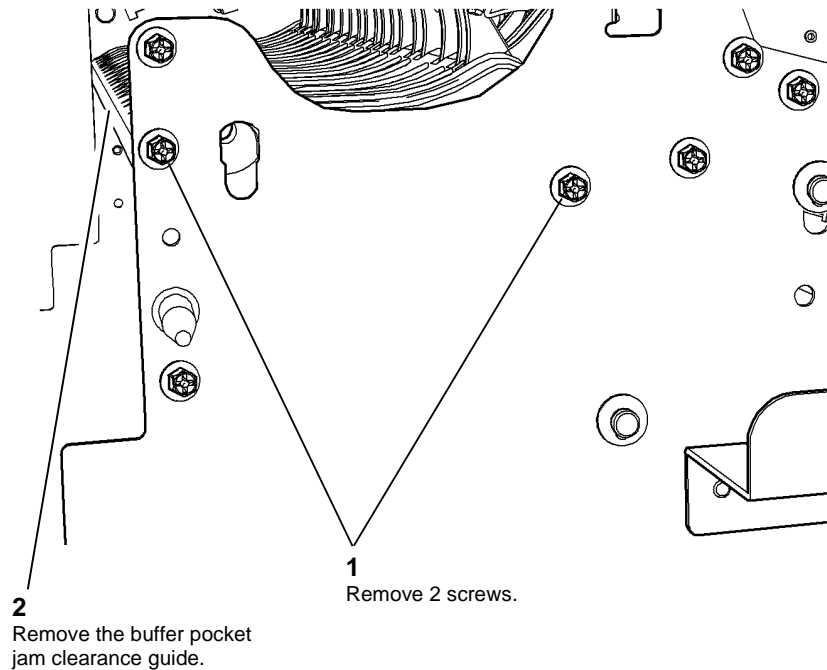
Figure 2 Guide removal

7. **Figure 2.** At the front of the HVF, remove the guide.

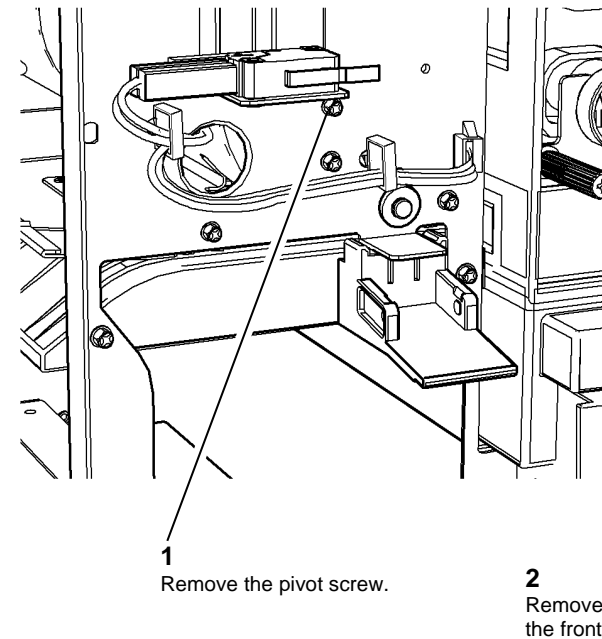
Figure 1 Guide removal.

1. Remove the HVF front door, **REP 12.1-171**
2. Remove the HVF top cover, **REP 12.1-171.**
3. Remove the HVF front cover, **REP 12.1-171.**
4. **Figure 1.** Remove the Inserter jam clearance guide.

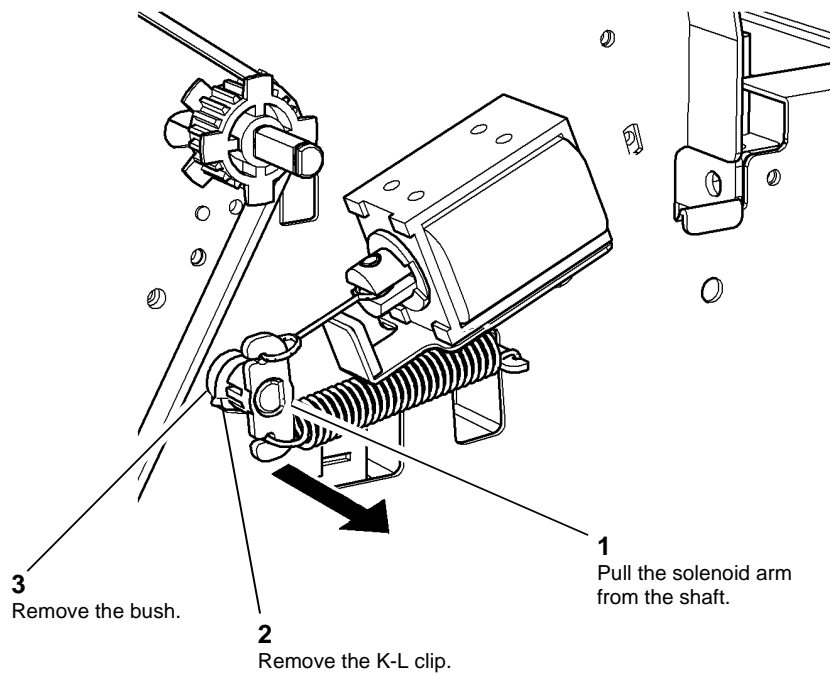
REAR VIEW

Figure 1 Removal preparation

1. Remove the HVF front door, [REP 12.1-171](#).
2. Remove the HVF top cover, [REP 12.1-171](#).
3. Remove the HVF front cover, [REP 12.1-171](#).
4. Remove the HVF rear cover, [REP 12.1-171](#).
5. [Figure 1](#). Prepare to remove the exit gate.

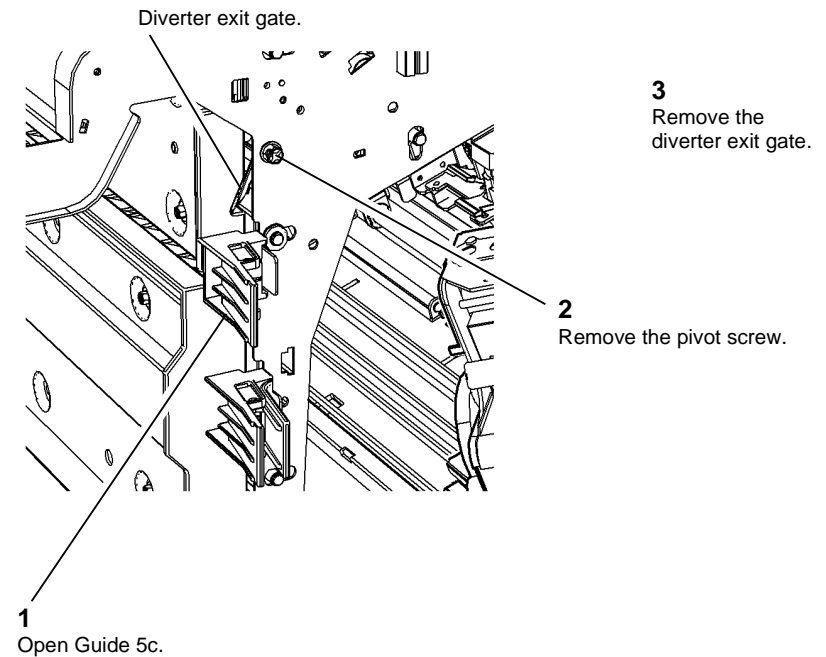
Figure 2 Diverter removal

6. [Figure 2](#). Remove the diverter exit gate.

After replacement, check the K-L clip is in the correct groove, and the bush cannot be pulled from the frame.

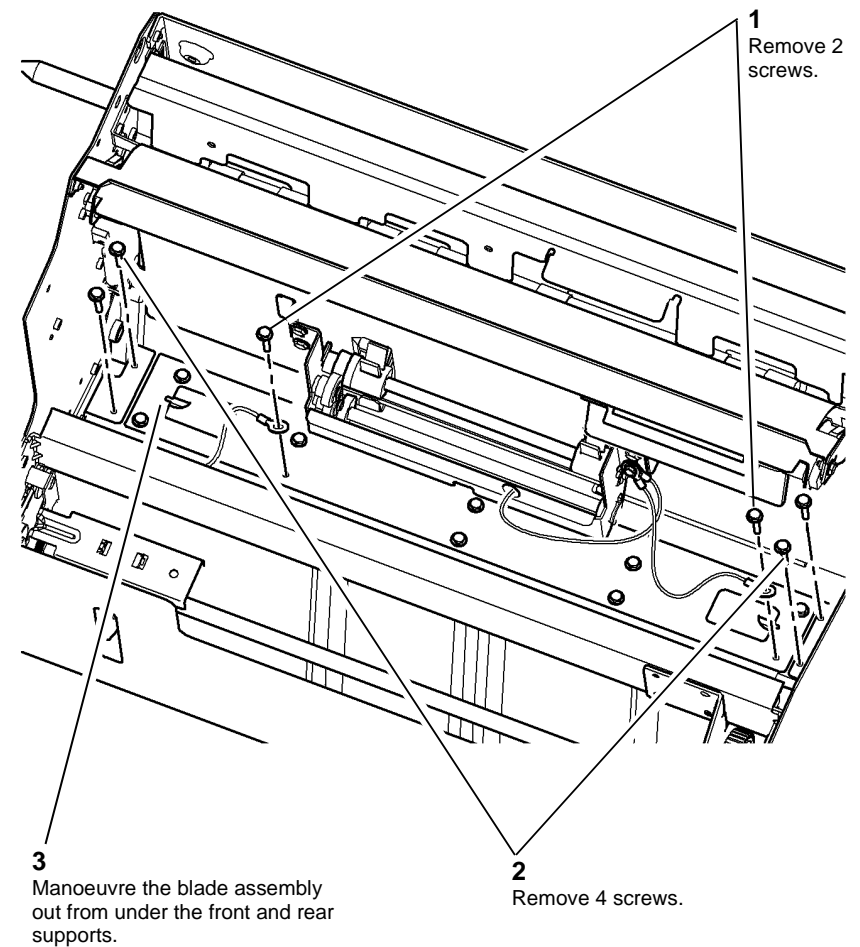
Figure 1 Crease blade assembly removal

5. [Figure 1](#), remove the crease blade assembly.

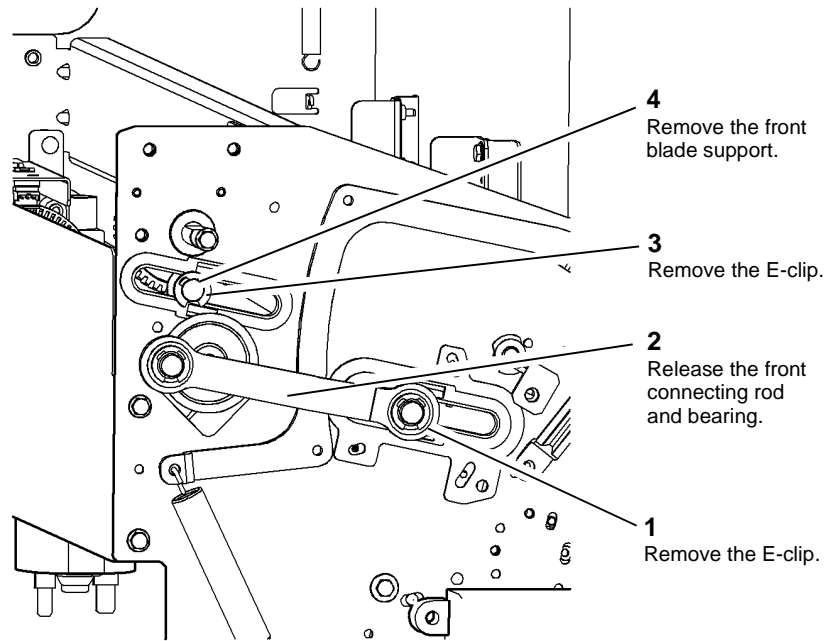
Figure 2 Front support removal

6. Figure 2, remove the front blade support.

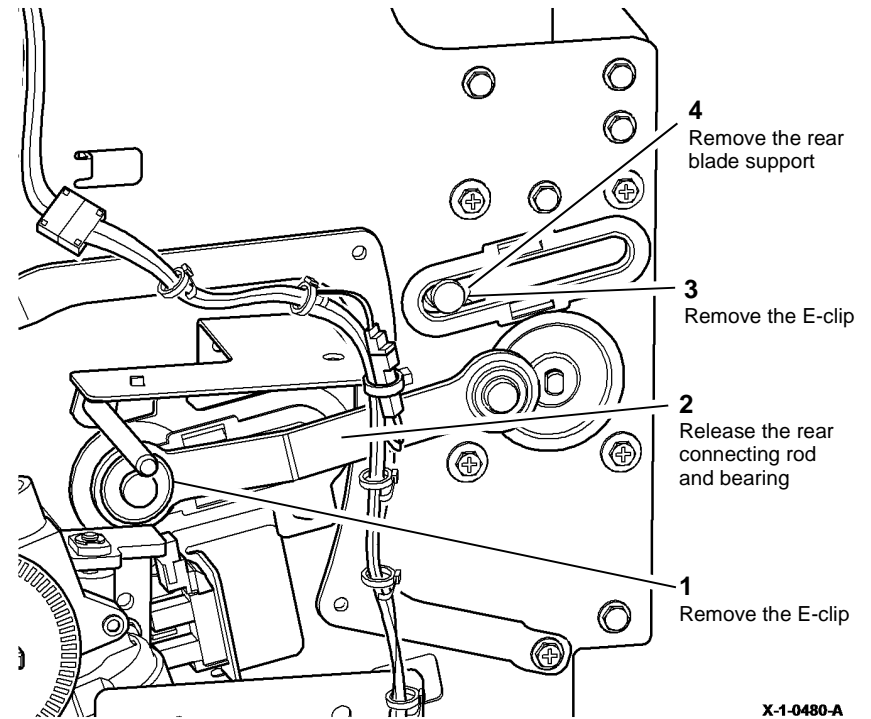
Figure 3 Rear support removal

7. Figure 3, remove the rear blade support.

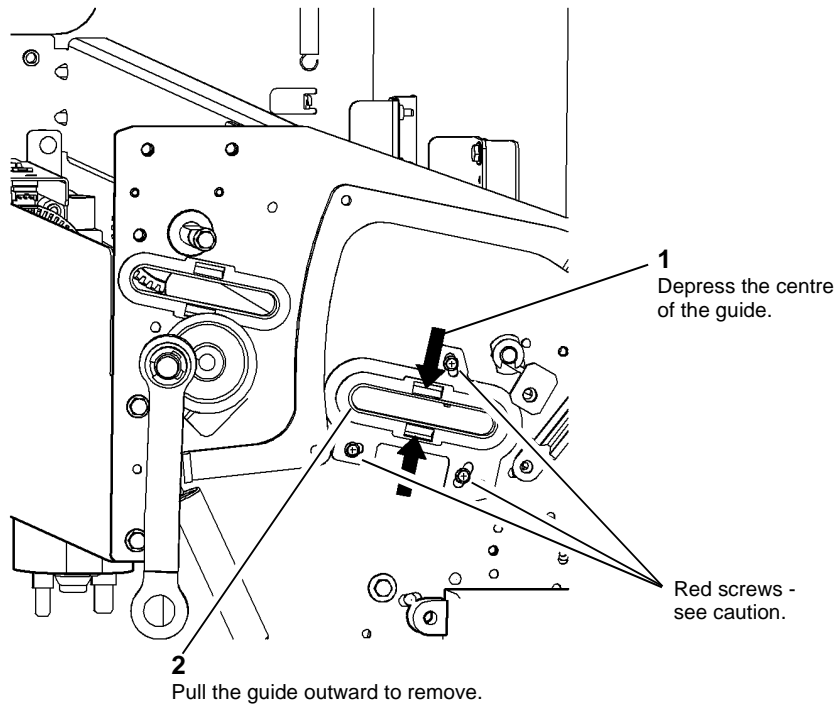
Figure 4 Support guide removal

Do not loosen the three red screws that surround the lower support guides

8. **Figure 4**, remove the support guides (4 places).

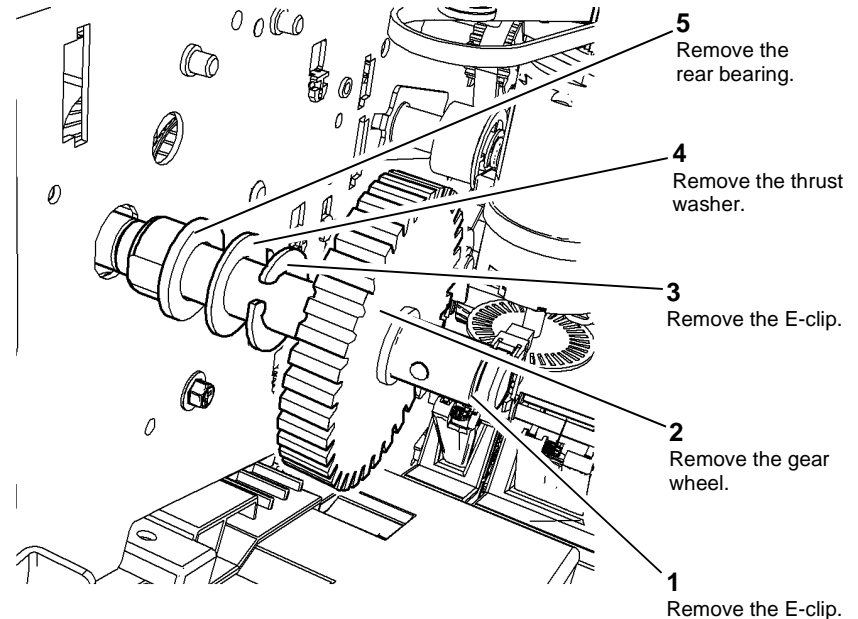
1. Remove the front and rear covers **REP 12.1-171**.
2. Remove the stacker motor and gear assembly **REP 12.12-171**.
3. Remove the rear bearing, **Figure 1**.

Figure 1 Rear bearing removal

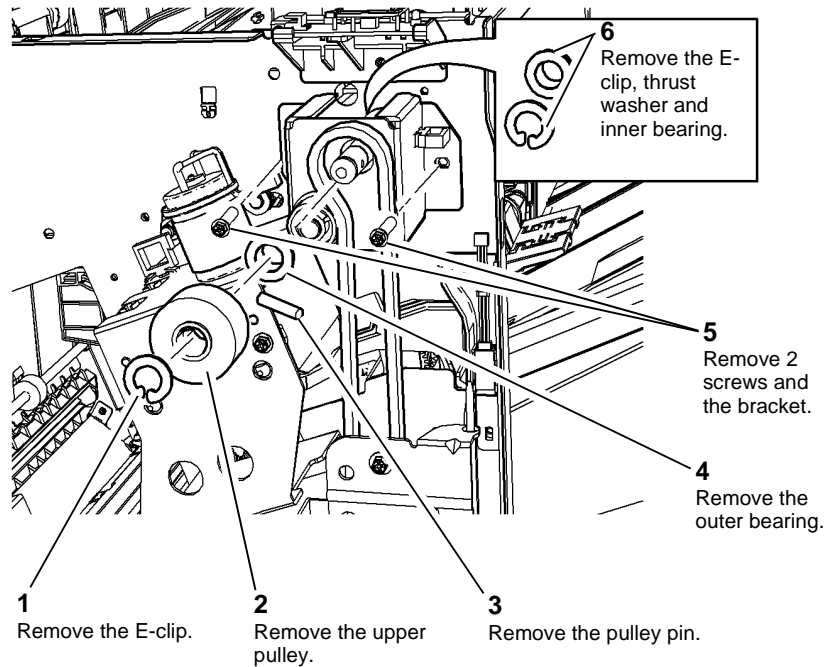
4. Remove the front bearings, [Figure 2](#).

Figure 2 Stacker Shaft Front Bearing

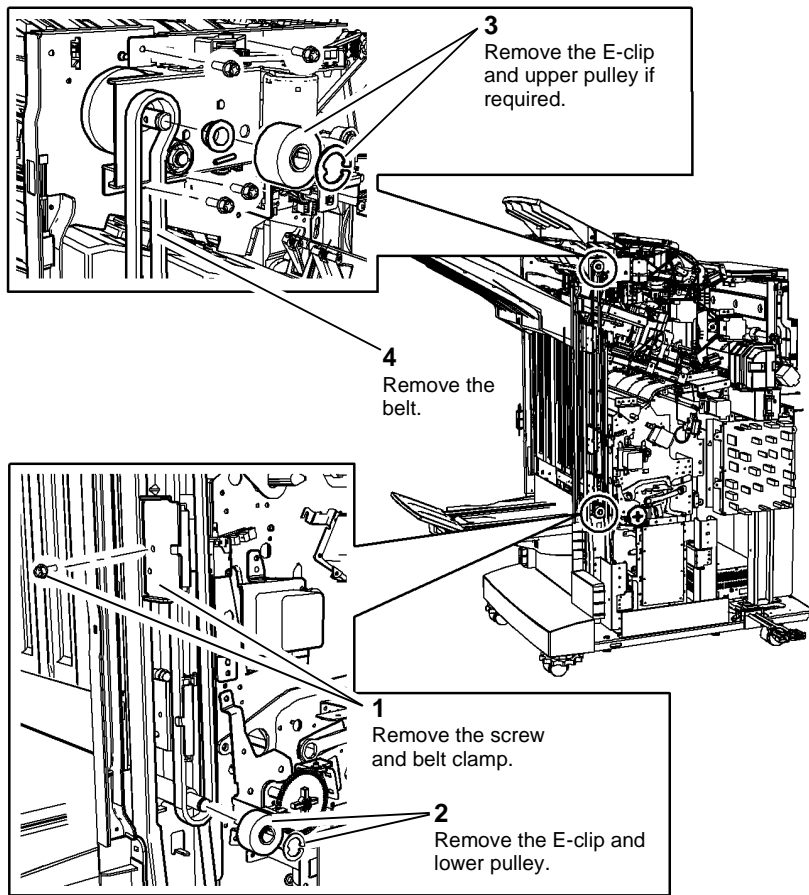
NOTE: The removal and replacement procedure for the front and rear bin 1 main drive belts is the same. Support the bin 1 lift bar if removing the front and rear belts at the same time

- Remove the bin 1 main drive belts, [Figure 1](#).

Figure 1 Bin 1 main drive belts

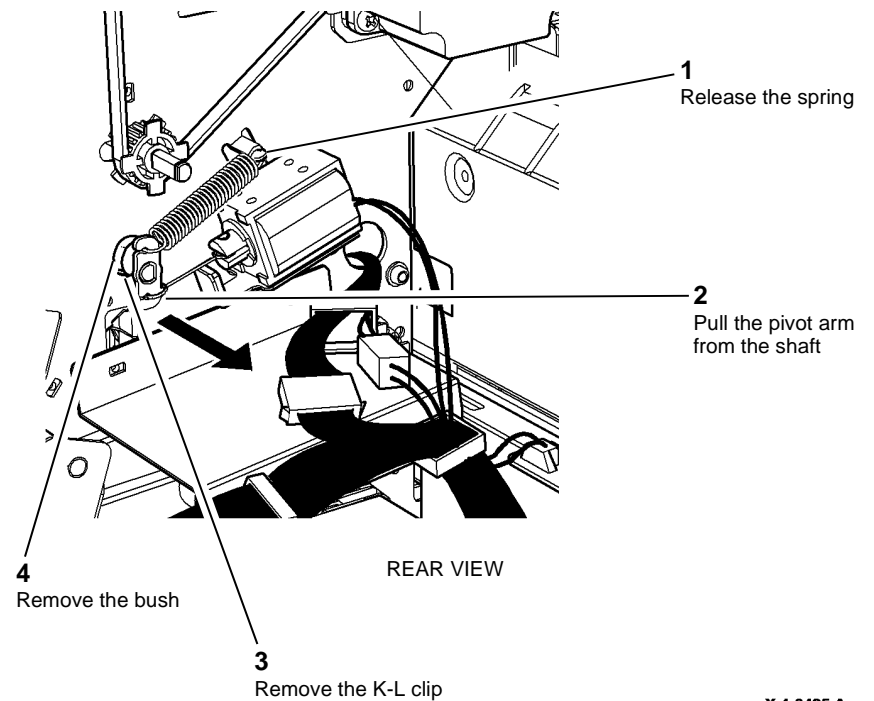
- Remove the HVF front door, [REP 12.1-171](#).
- Remove the HVF top cover, [REP 12.1-171](#).
- Remove the HVF front cover, [REP 12.1-171](#).
- Remove the HVF rear cover, [REP 12.1-171](#).
- [Figure 1](#). prepare to remove the BM diverter gate.

Figure 1 Removal preparation

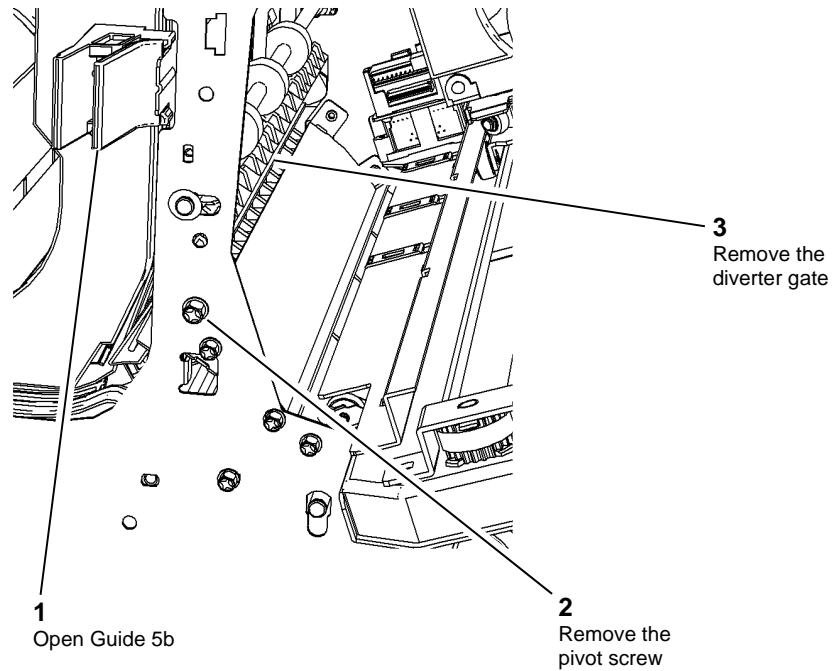
6. **Figure 2.** Remove the BM diverter gate.

Figure 2 Diverter removal.

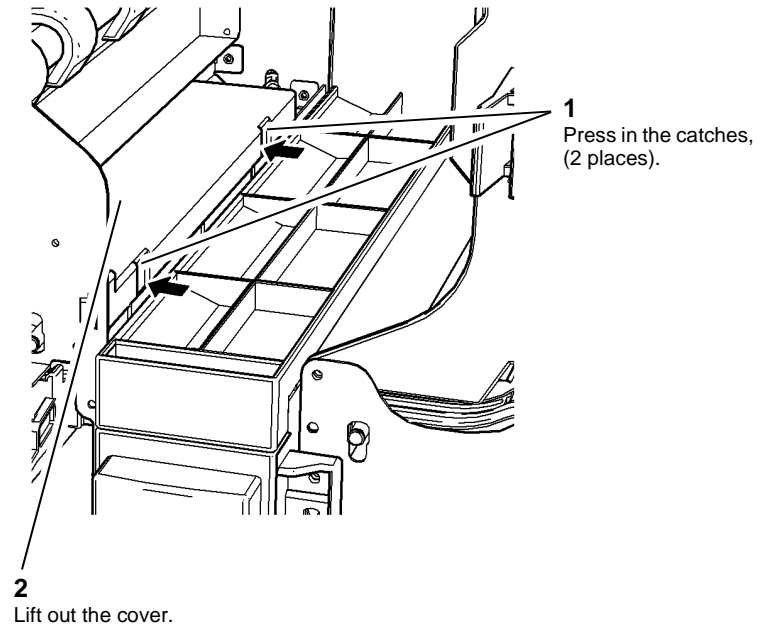
1. Remove the HVF front door, **REP 12.1-171.**
2. Remove the HVF top cover, **REP 12.1-171.**
3. Remove the HVF front cover, **REP 12.1-171.**
4. Remove the HVF rear cover, **REP 12.1-171.**
5. **Figure 1.** Remove the black plastic cover.

Figure 1 Cover removal.

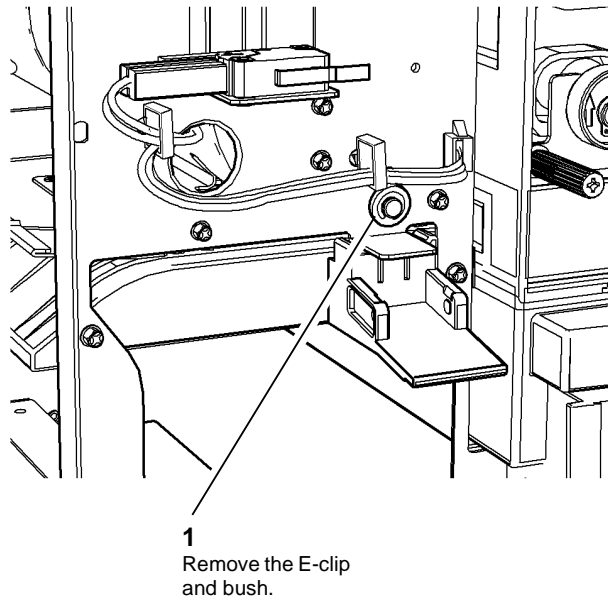
6. **Figure 2.** Prepare to remove the input roll.

Figure 2 Preparation

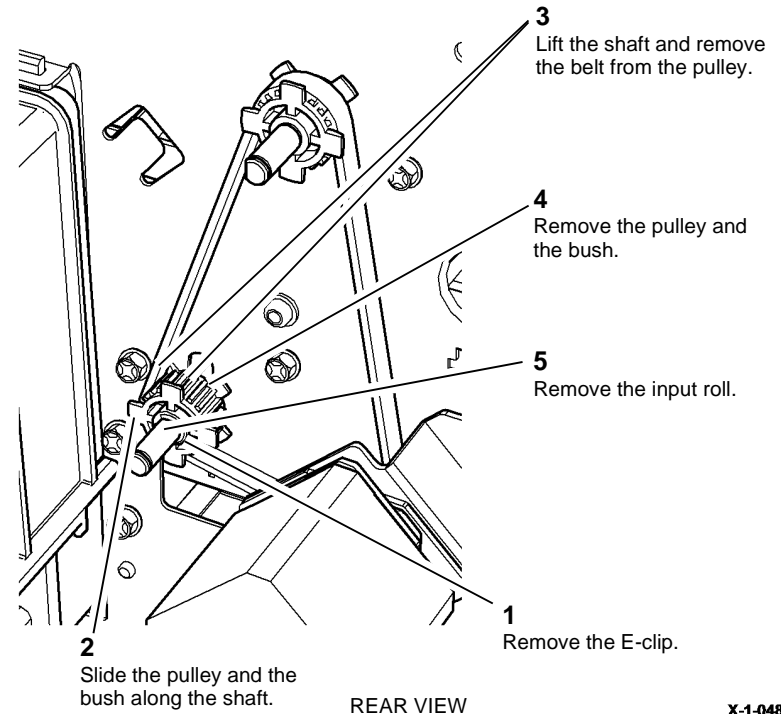
7. **Figure 3.** At the rear of the HVF, remove the input roll.

Figure 3 Input roll removal.

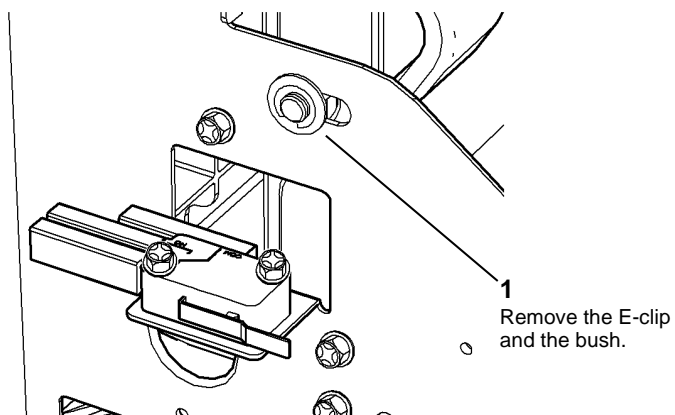
1. Remove the HVF front door, [REP 12.1-171](#).
2. Remove the HVF top cover, [REP 12.1-171](#).
3. Remove the HVF front cover, [REP 12.1-171](#).
4. Remove the HVF rear cover, [REP 12.1-171](#).
5. Open guide 8a.
6. [Figure 1](#). At the front of the HVF, remove the E-clip and the bush.

Figure 1 E-clip and bush removal.

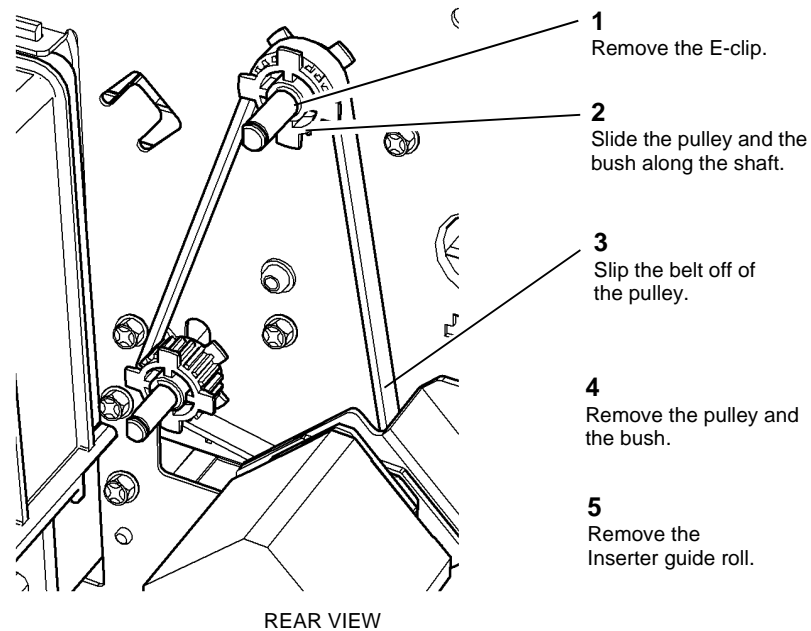
7. [Figure 2](#). At the rear of the HVF, remove the Inserter guide roll.

Figure 2 Inserter guide roll removal

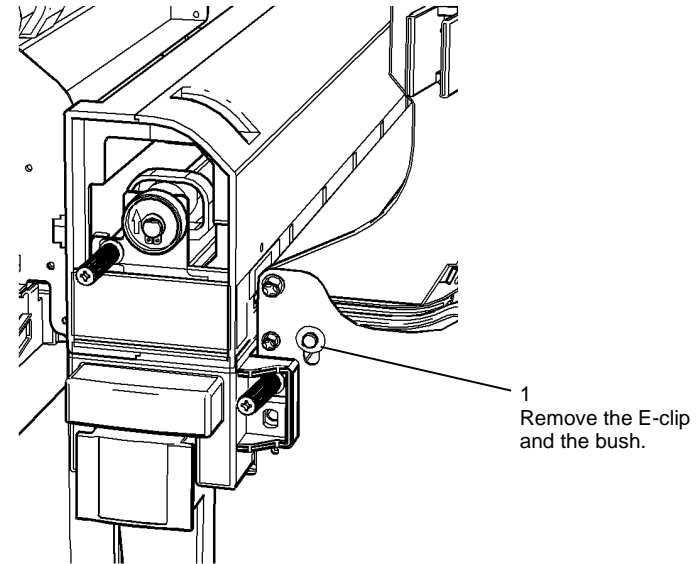
1. Remove the HVF front door, [REP 12.1-171](#).
2. Remove the HVF top cover, [REP 12.1-171](#).
3. Remove the HVF front cover, [REP 12.1-171](#).
4. Remove the HVF rear cover, [REP 12.1-171](#).
5. Remove the punch unit, or the punch unit guide, as appropriate.
6. [Figure 1](#). At the front of the HVF, remove the E-clip and bush.

Figure 1 E-clip and bush removal.

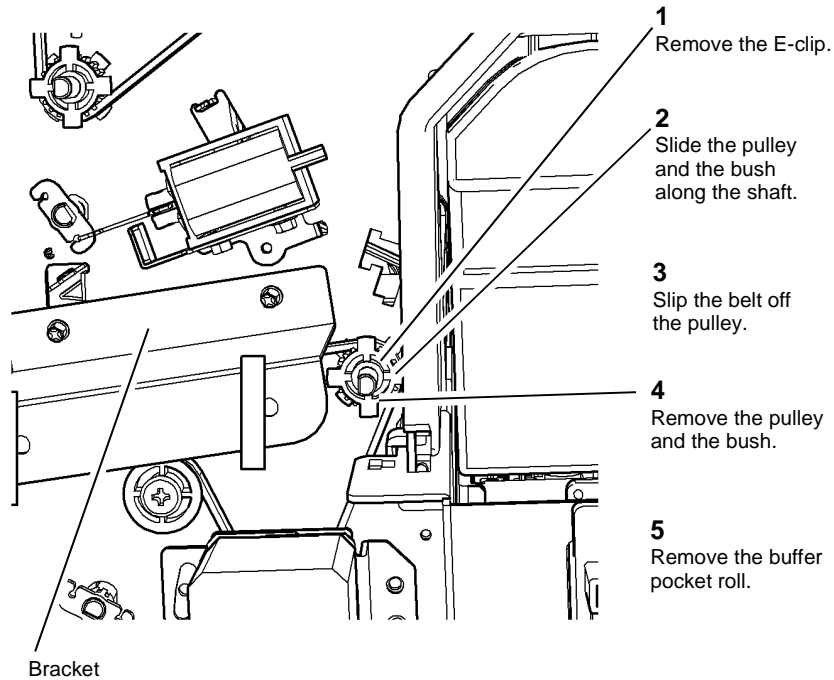
- At the rear of the HVF, remove the buffer pocket roll. The bracket can be moved if necessary, to improve access, (two screws), [Figure 2](#).

Figure 2 Buffer pocket roll removal.

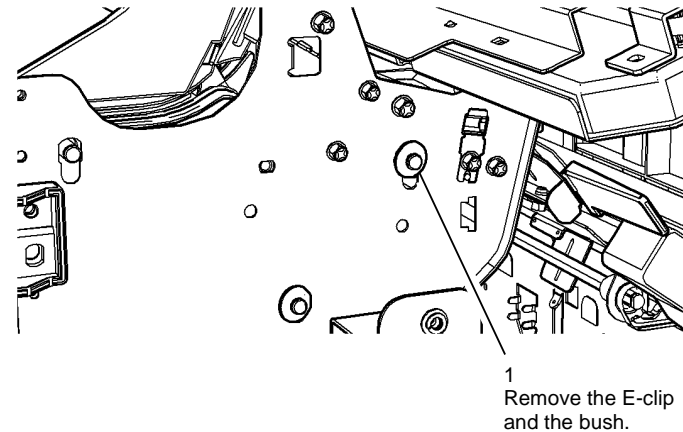
- Remove the HVF front door, [REP 12.1-171](#).
- Remove the HVF top cover, [REP 12.1-171](#).
- Remove the HVF front cover, [REP 12.1-171](#).
- Remove the HVF rear cover, [REP 12.1-171](#).
- [Figure 1](#). Remove the E-clip and bush at the outboard end of the roll.

1 Remove the E-clip and the bush.

Figure 1 E-clip and bush removal.

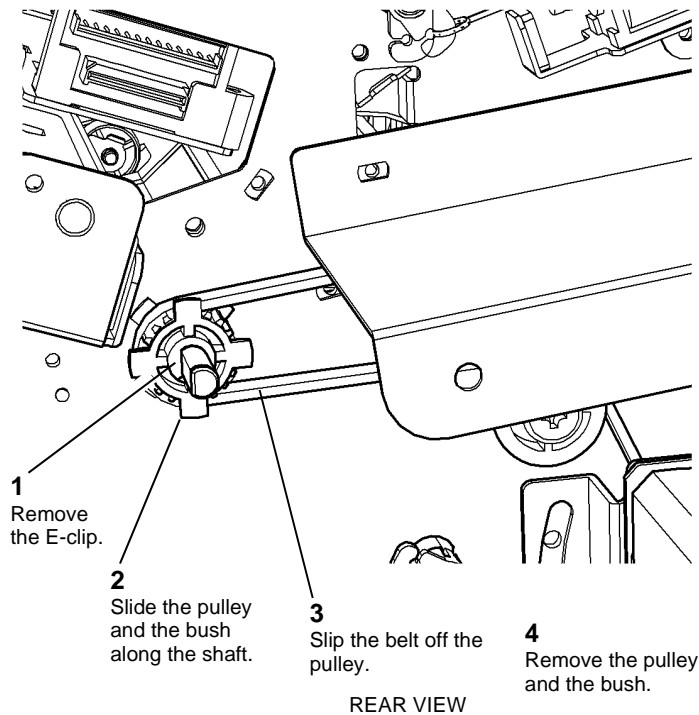
6. **Figure 2.** At the rear of the HVF, remove the booklet entrance roll.

Figure 2 Booklet entrance roll removal.

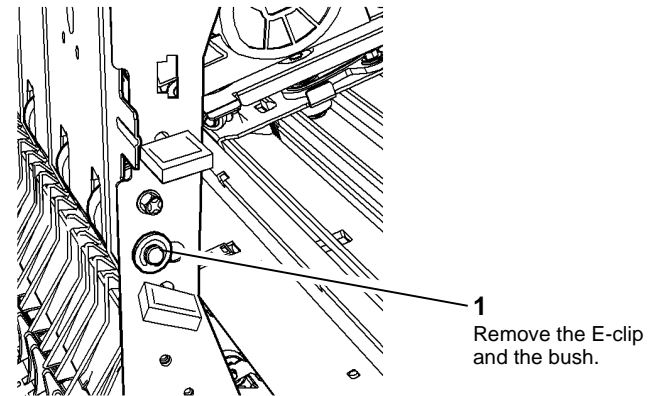
Figure 1 E-clip and bush removal.

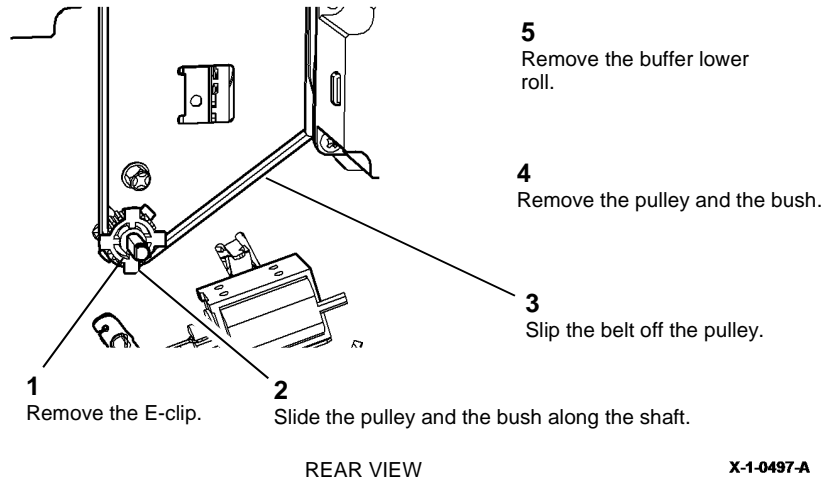
7. **Figure 2.** At the rear of the HVF, remove the buffer lower roll.

Figure 2 Buffer lower roll removal.

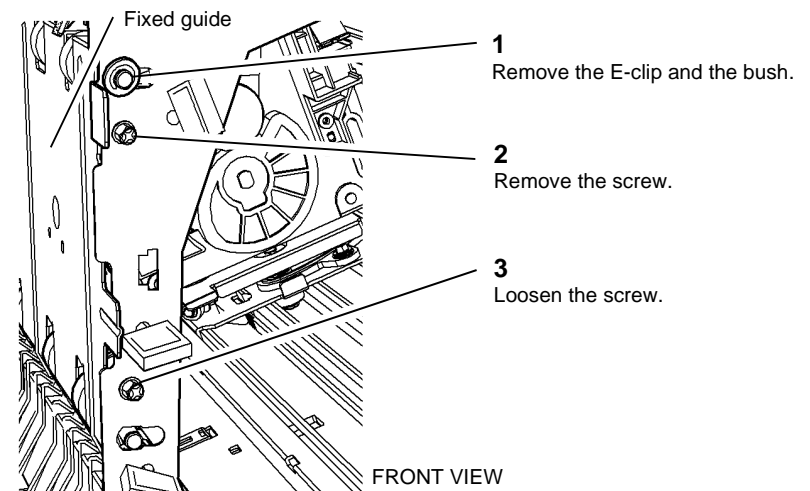
1. Remove the HVF front door, **REP 12.1-171.**
2. Remove the HVF top cover, **REP 12.1-171.**
3. Remove the HVF front cover, **REP 12.1-171.**
4. Remove the HVF rear cover, **REP 12.1-171.**
5. **Figure 1.** Prepare to remove the buffer upper roll.

Figure 1 Preparation

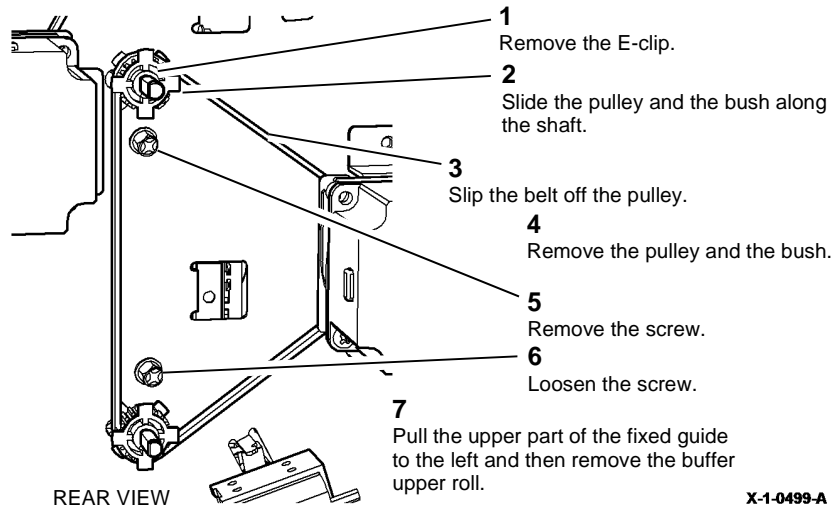
6. [Figure 2](#). Remove the buffer upper roll.

Figure 2 Buffer upper roll removal.

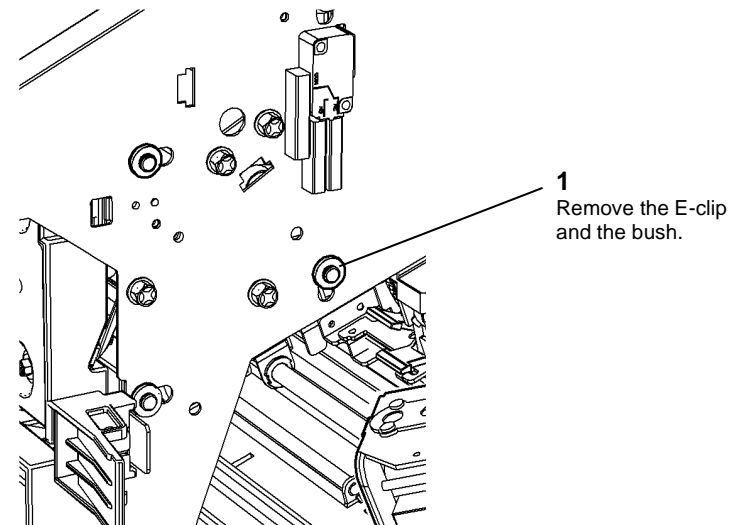
1. Remove the HVF front door, [REP 12.1-171](#).
2. Remove the HVF top cover, [REP 12.1-171](#).
3. Remove the HVF front cover, [REP 12.1-171](#).
4. Remove the HVF rear cover, [REP 12.1-171](#).
5. [Figure 1](#). Remove the E-clip and bush

Figure 1 E-clip and bush removal.

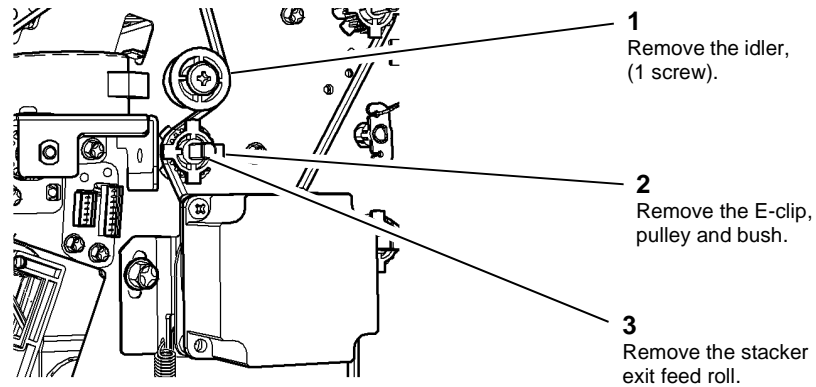
6. **Figure 2.** Remove the stacker exit feed roll.

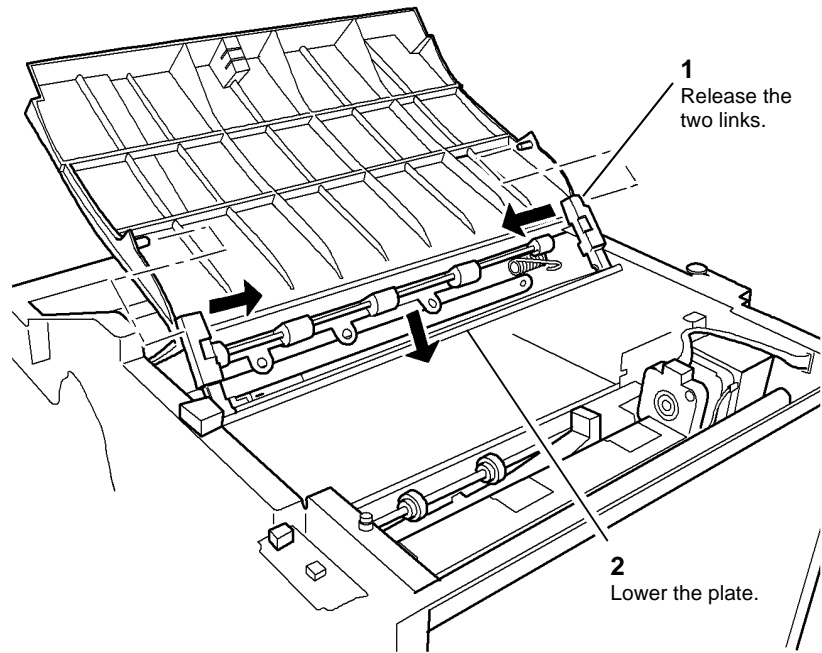
6. **Figure 1.** Raise the top tray and lower the plate beneath it.

Figure 1 Lowering the plate.

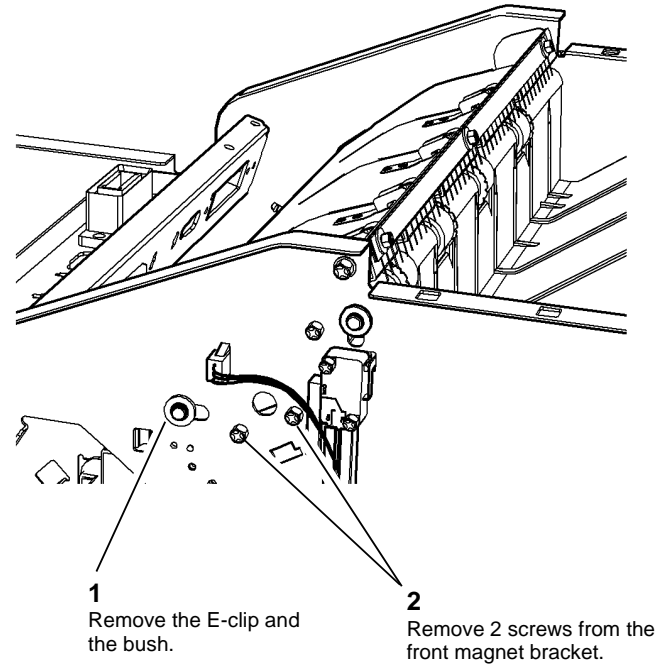
7. **Figure 2.** Remove the front components.

Figure 2 Front component removal

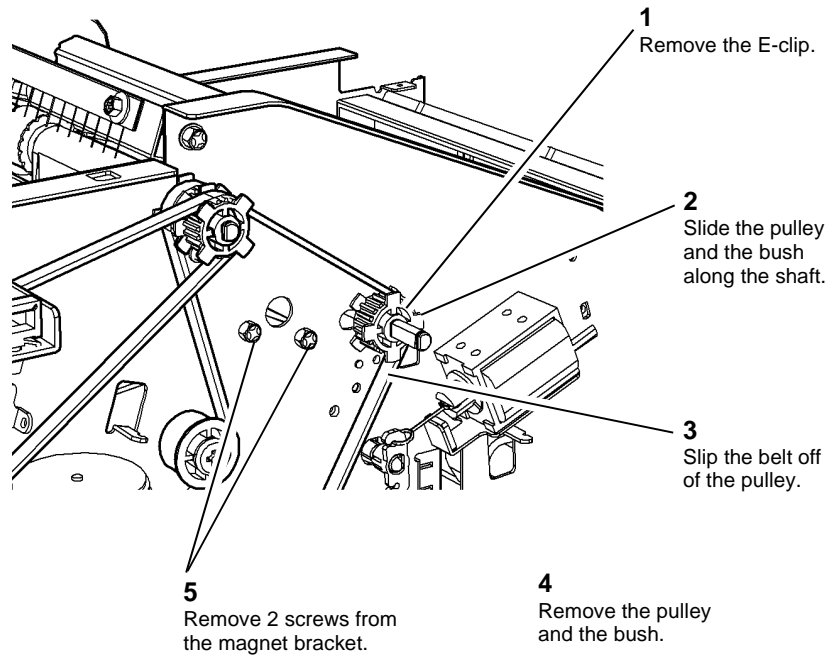
8. **Figure 3.** Remove the rear components.

Figure 3 Rear component removal.

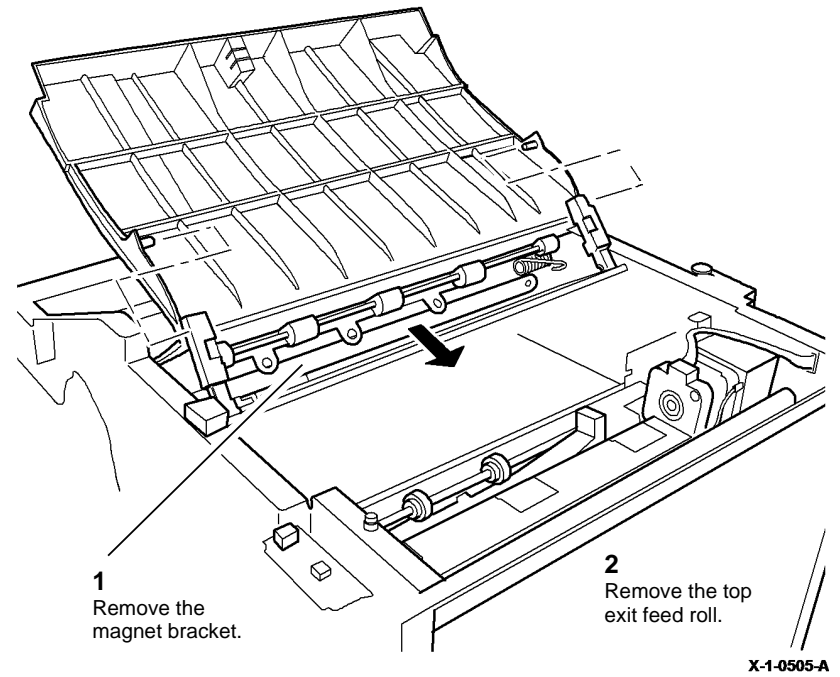
9. **Figure 4.** Remove the top exit roll.

Figure 4 Top exit roll removal.

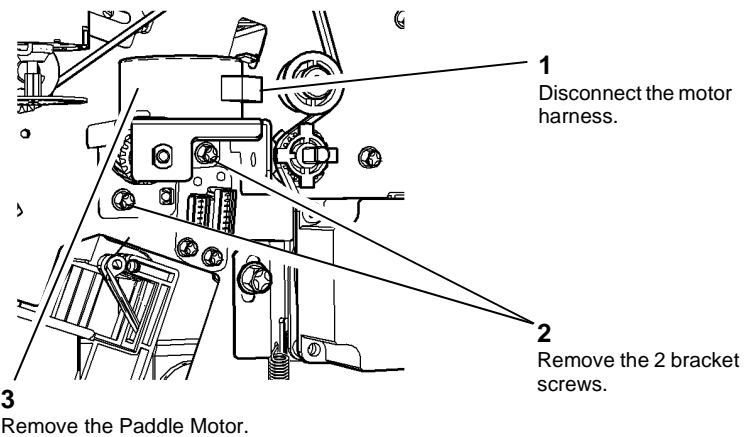
1. Remove the rear cover [REP 12.1-171](#).
2. Remove the paddle motor assembly, [Figure 1](#).

Figure 1 Paddle motor assembly
