708P91368
September 2017

Xerox® AltaLink® B8090 Family Multifunction Printer Service Manual

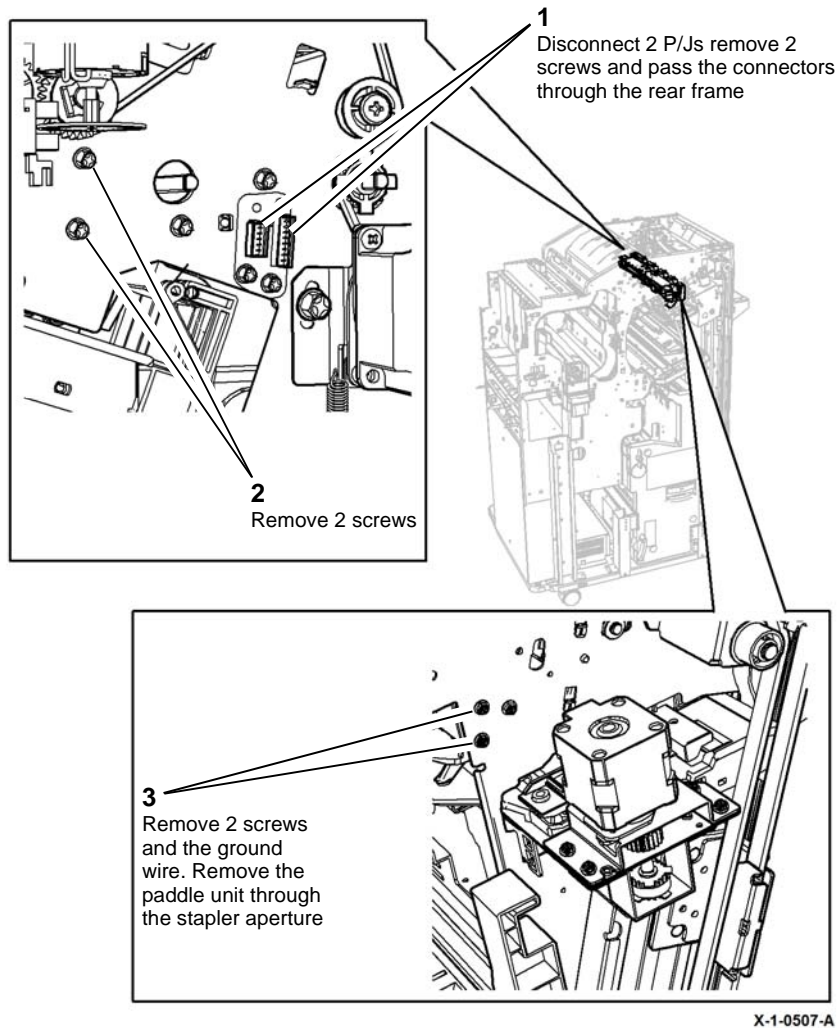
NOTE: The motor coupler should detach with the motor assembly. If the coupler fails to detach, remove the coupler from the paddle unit.

4. Figure 1, remove the paddle unit.

Figure 1 Paddle unit attachment

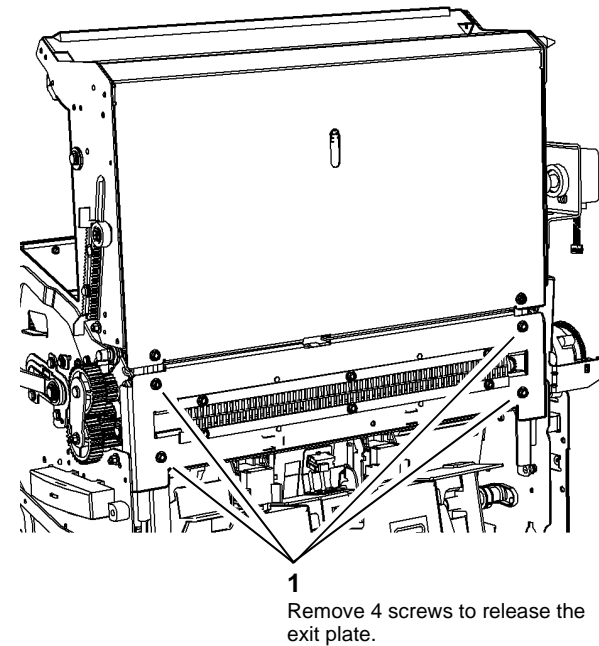
1. Remove the BM right hand cover, [REP 12.56-171](#).
2. Remove the exit plate, [Figure 1](#).

Figure 1 Remove the exit plate

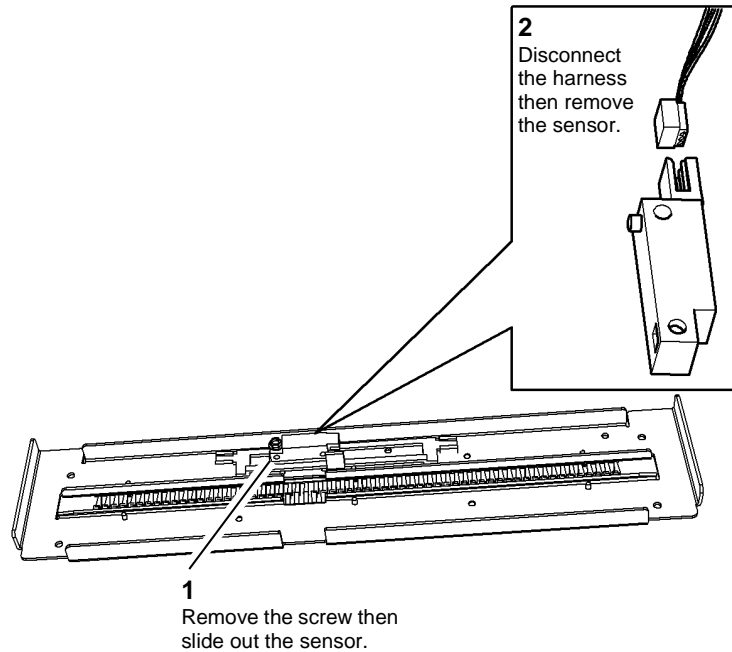
3. Figure 2, remove the BM exit sensor.

Figure 2 Sensor removal

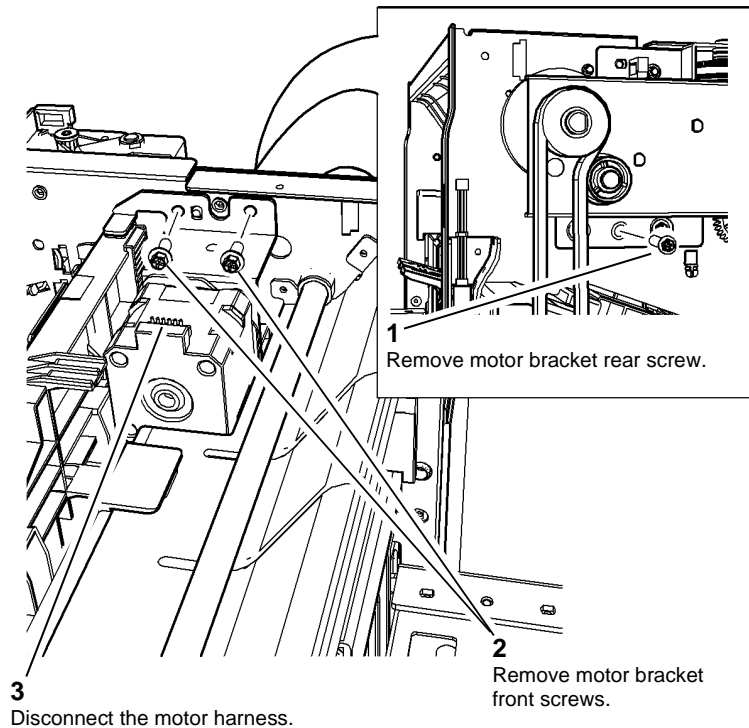
1. Remove the top and rear covers [REP 12.1-171](#).
2. Remove the paper pusher motor assembly, [Figure 1](#).

Figure 1 Motor removal

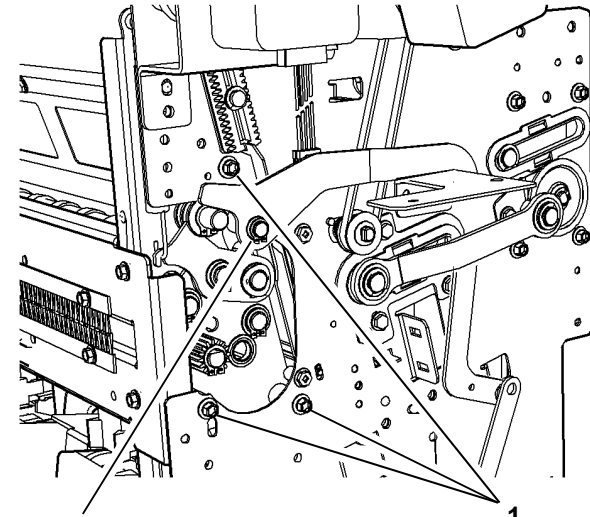
9. [Figure 1](#), Release the crease roll assembly at the rear.

2
Remove E-clip and release the arm.

1
Remove 3 screws.

Figure 1 Rear fasteners release

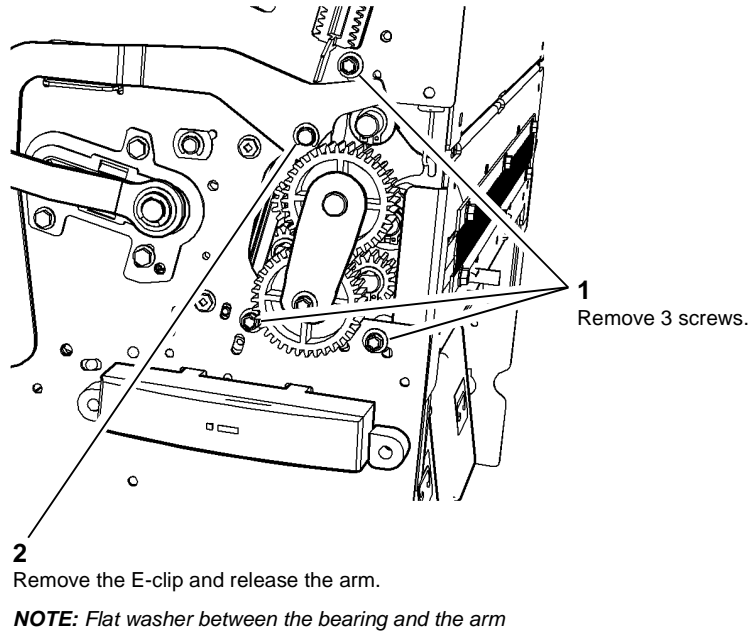
10. **Figure 2**, Release the crease roll assembly at the front.

Figure 2 Front fasteners release

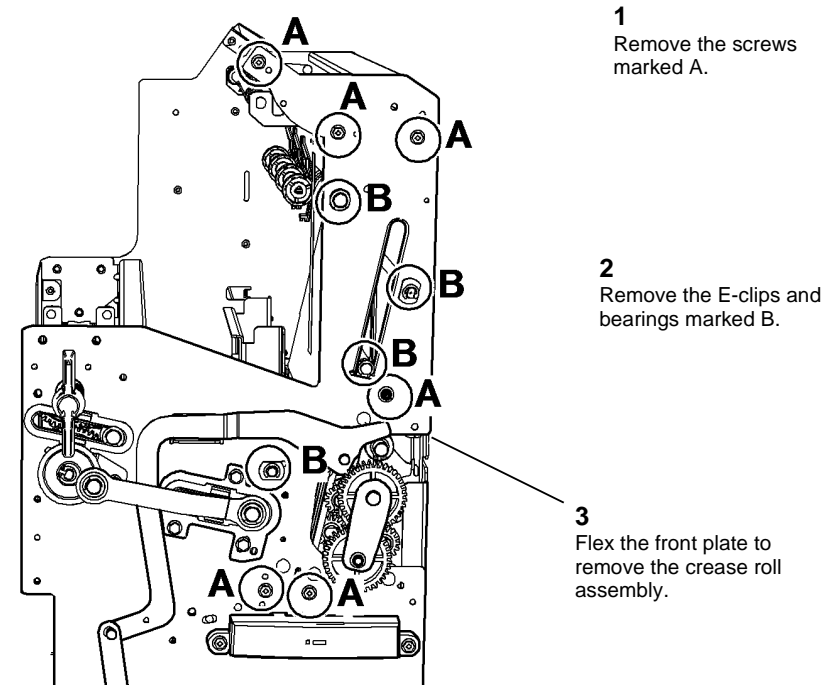
11. **Figure 3**, remove the crease roll assembly.

Figure 3 Release the front plate

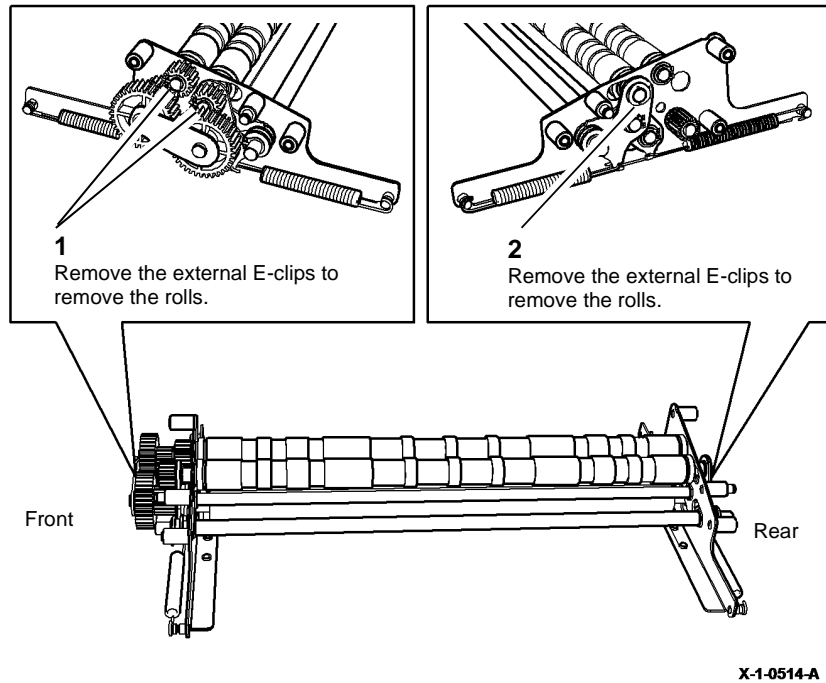
12. Figure 4, remove the crease rolls.

Figure 4 Remove the crease rolls

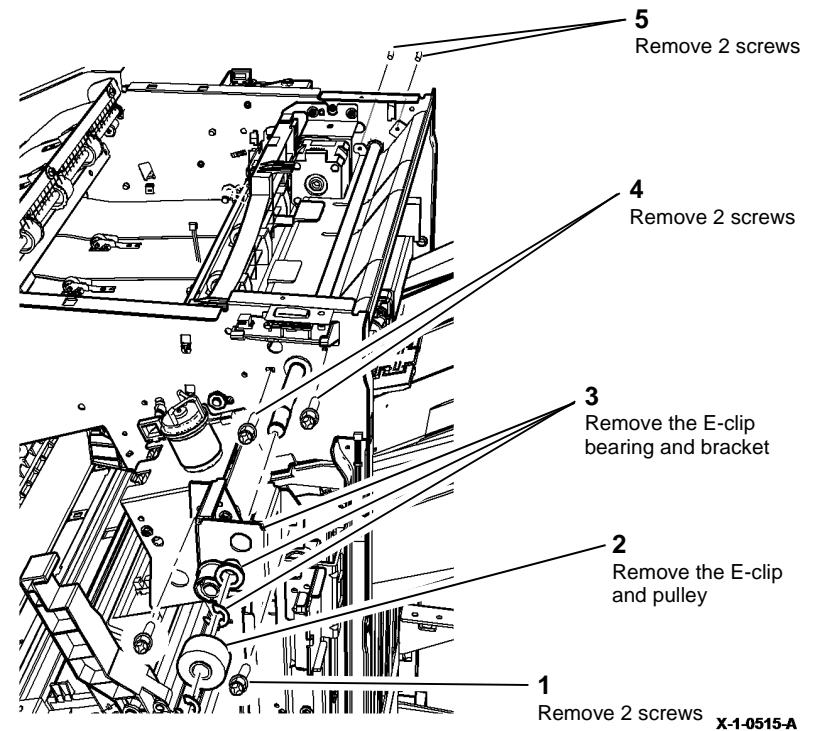
1. Remove the front, rear and top covers [REP 12.1-171](#).
2. Remove the front and rear bin 1 main drive belts, [REP 12.38-171](#).
3. Remove the bin 1 elevator motor assembly, [REP 12.12-171](#).
4. Prepare to remove the paper pusher, [Figure 1](#).

Figure 1 Preparation

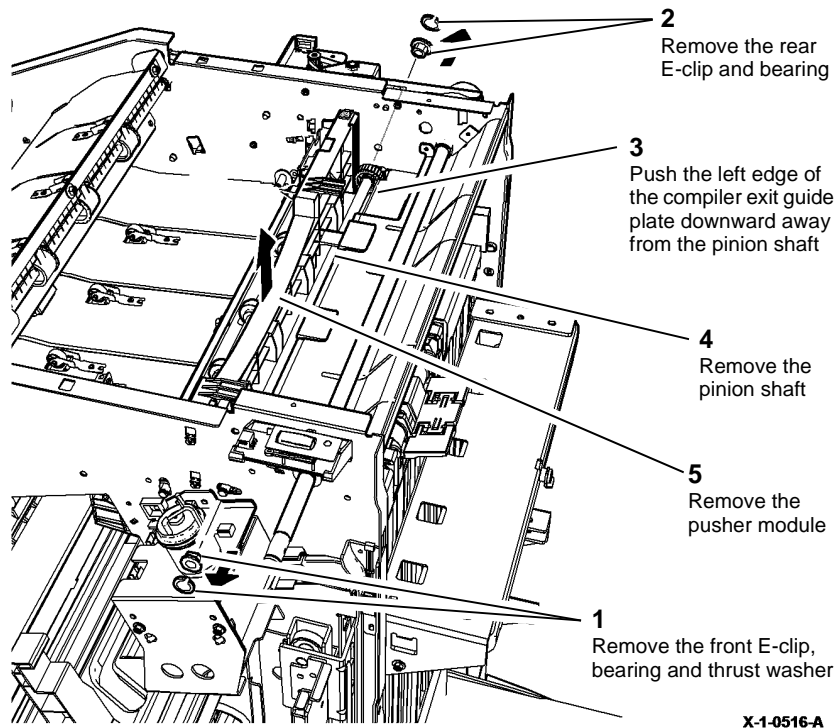
5. Remove the paper pusher motor assembly, [REP 12.51-171](#).
6. Remove the pusher sensor assembly, [REP 12.54-171](#).
7. Remove the paper pusher, [Figure 2](#).

Figure 2 Paper pusher removal

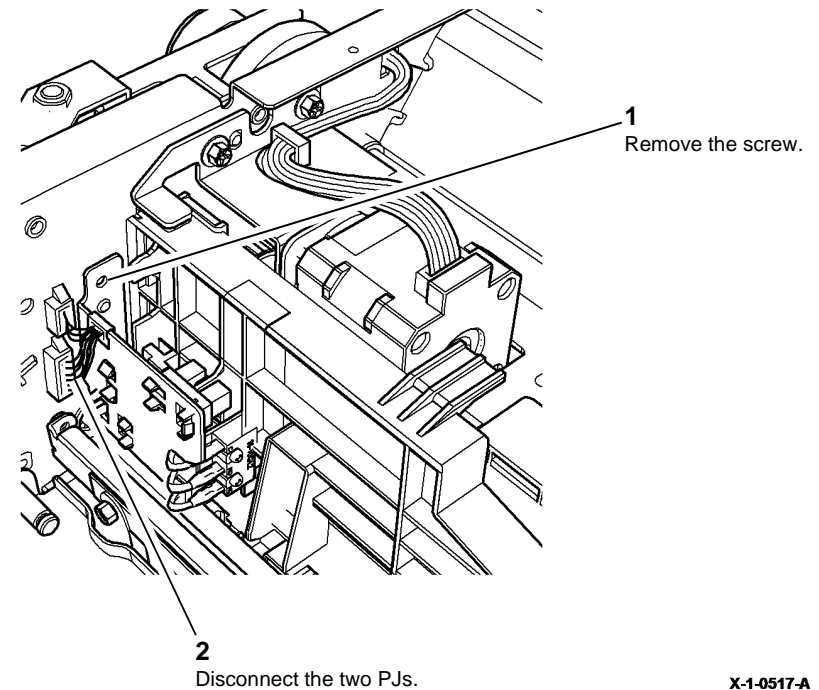
1. Remove the top cover [REP 12.1-171](#).
2. Remove the sensor assembly, [Figure 1](#).

Figure 1 Pusher Sensor Assembly

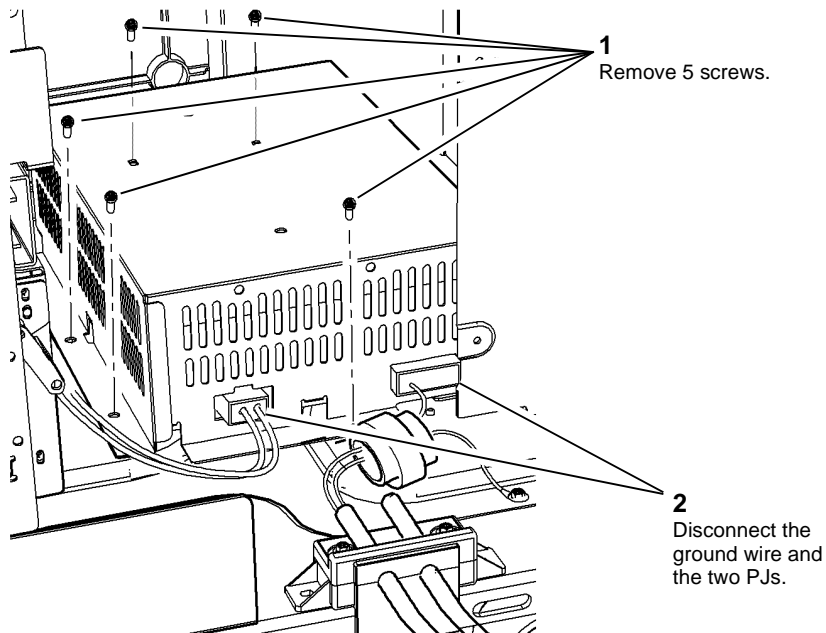
1. Remove the front and rear covers [REP 12.1-171](#).
2. Remove the power supply unit, [Figure 1](#).

Figure 1 Power supply unit removal

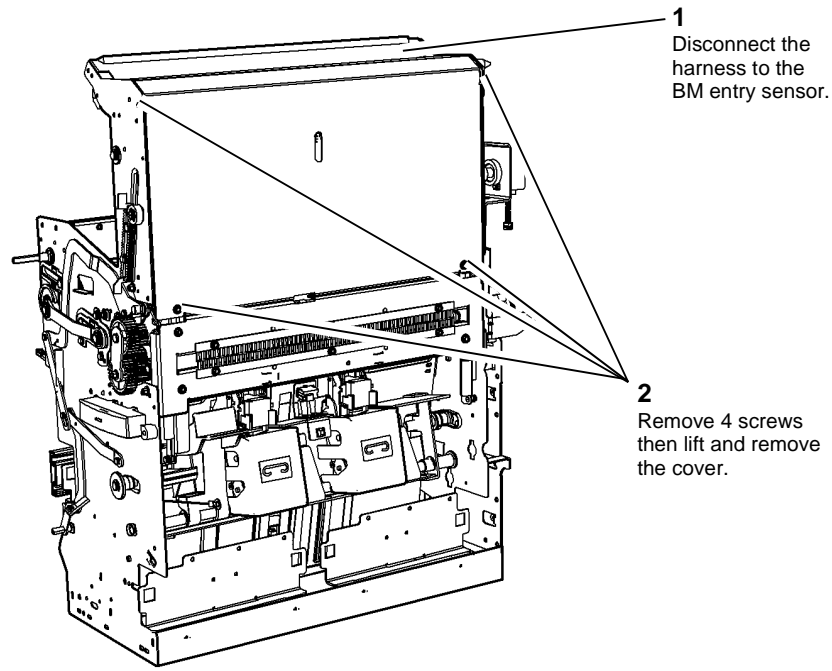
6. **Figure 1**, remove the BM right cover.

Figure 1 Right cover removal

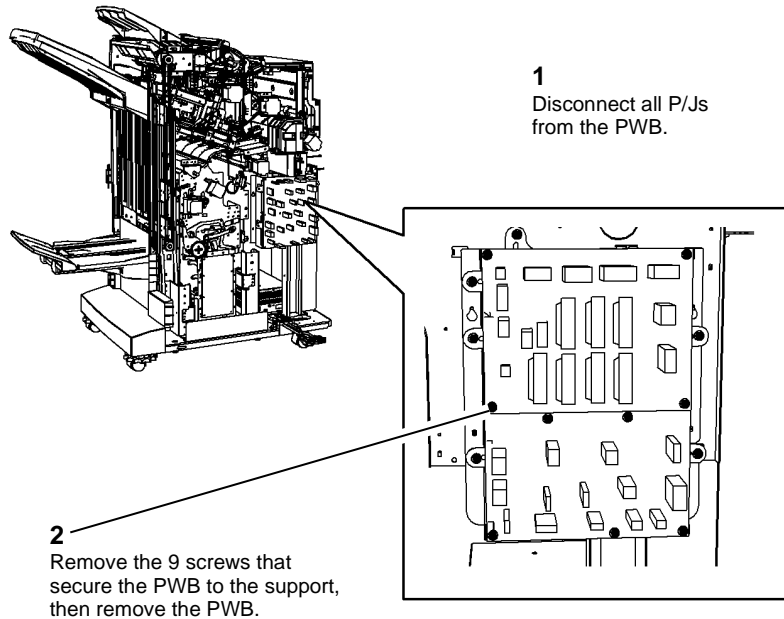
- Remove the HVF PWB, [Figure 2](#).

- Disconnect all P/J's from the PWB.

- Remove the 9 screws that secure the PWB to the support, then remove the PWB.

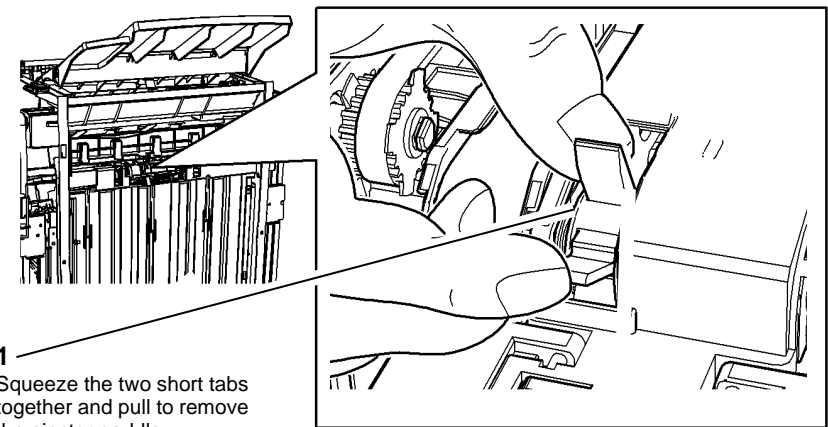
- Rotate the ejector paddle assembly until the two short tabs are visible.
- Remove the ejector paddle assembly, [Figure 1](#).

- Squeeze the two short tabs together and pull to remove the ejector paddle.

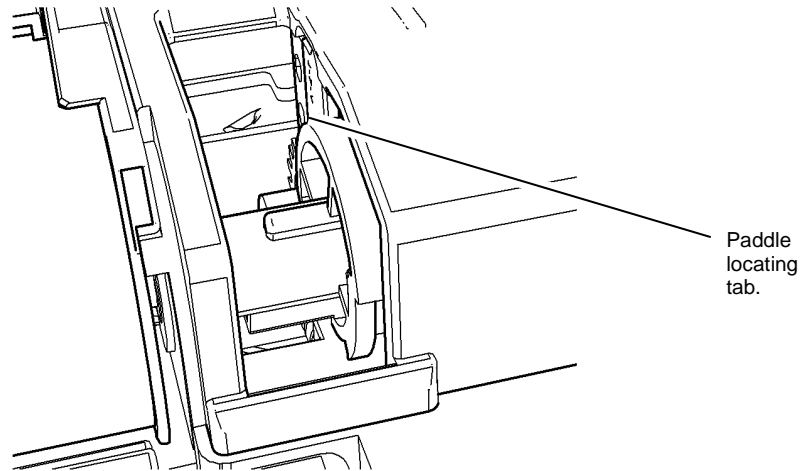
X-1-0592-A

1. Rotate the paddle shaft to ensure that the locating tab is uppermost, [Figure 2](#).
2. Ensure that the longest paddle is positioned towards the stacker tray.
3. Hold the paddle assembly by the two short tabs and clip onto the shaft.

Figure 2 Paddle locating tab

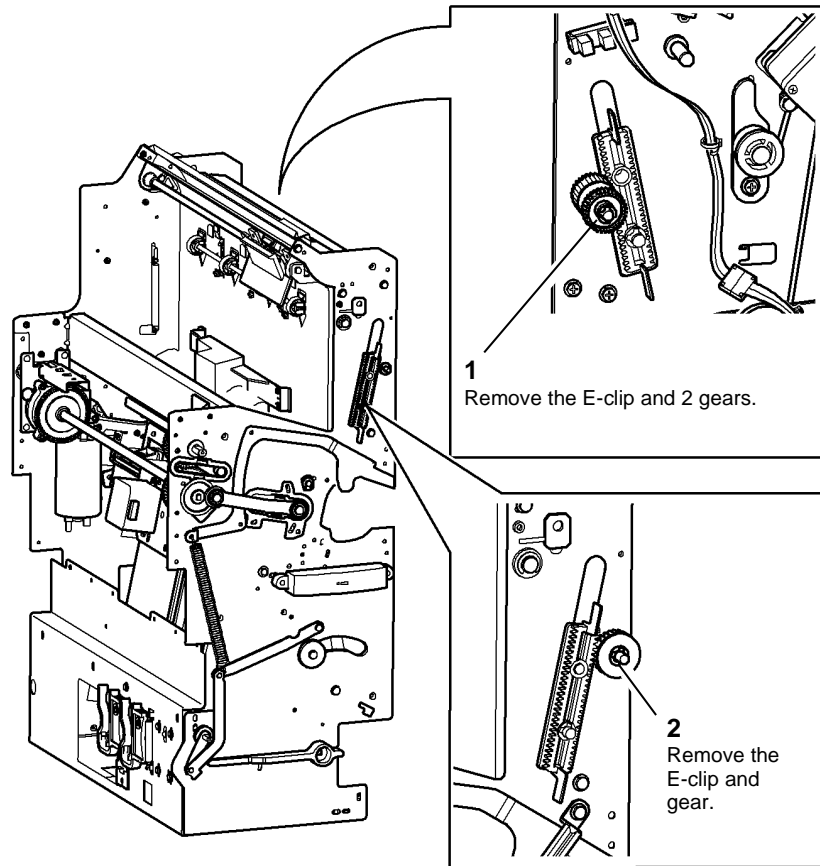
X-1-0521-A

8. Figure 1, remove the gate rack gears.

Figure 1 Removing gears

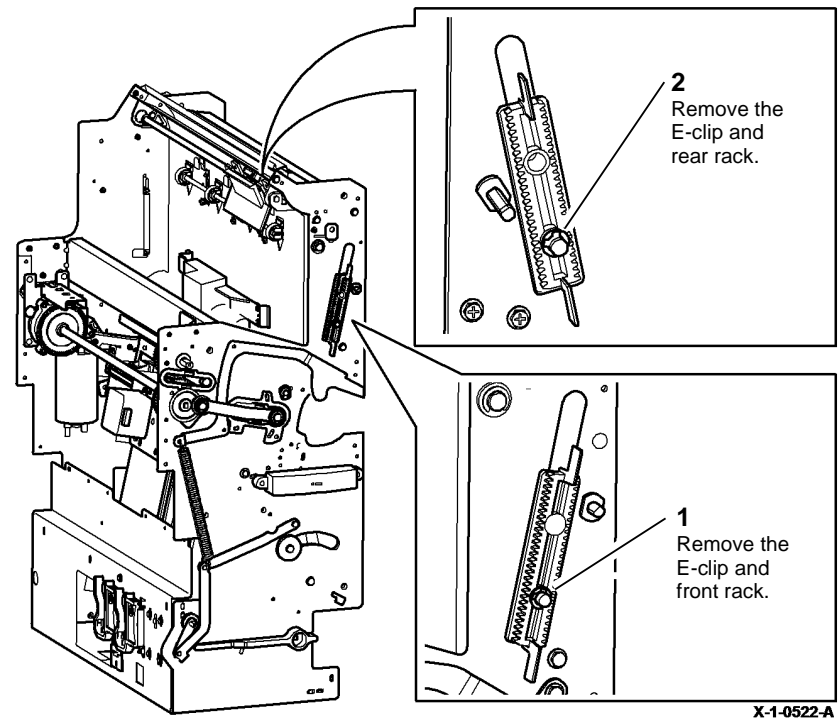
X-1-0522-A

9. Figure 2, Remove the front and rear crease roll gate racks.

Figure 2 Removing the racks

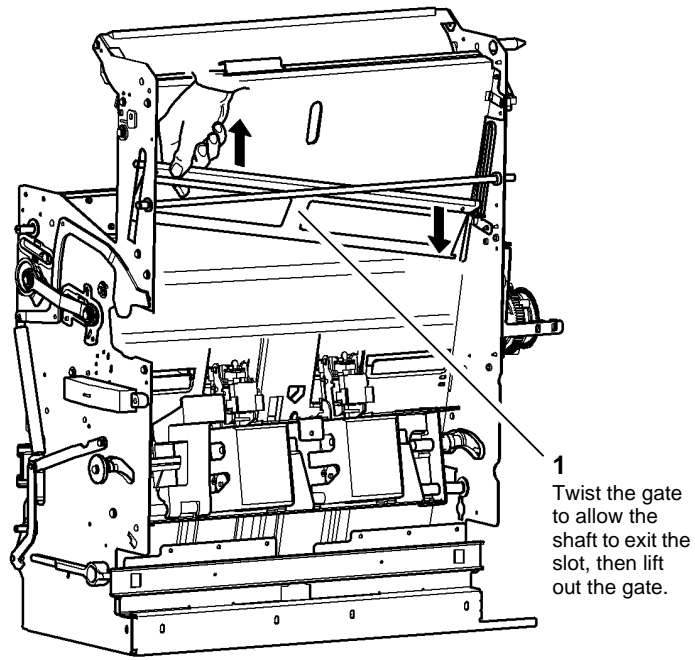
X-1-0523-A

10. Figure 3, remove the crease roll gate.

Figure 3 Gate removal

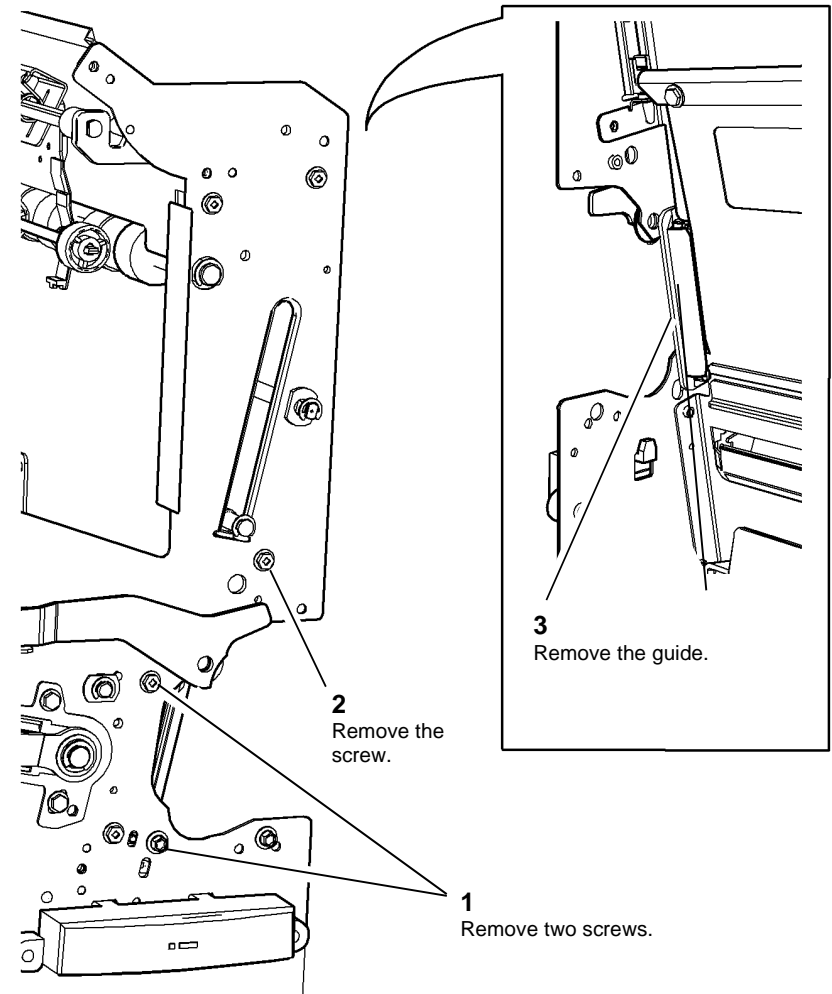
X-1-0524-A

11. Figure 4, remove the grease roll gate front guide.

Figure 4 Front guide removal

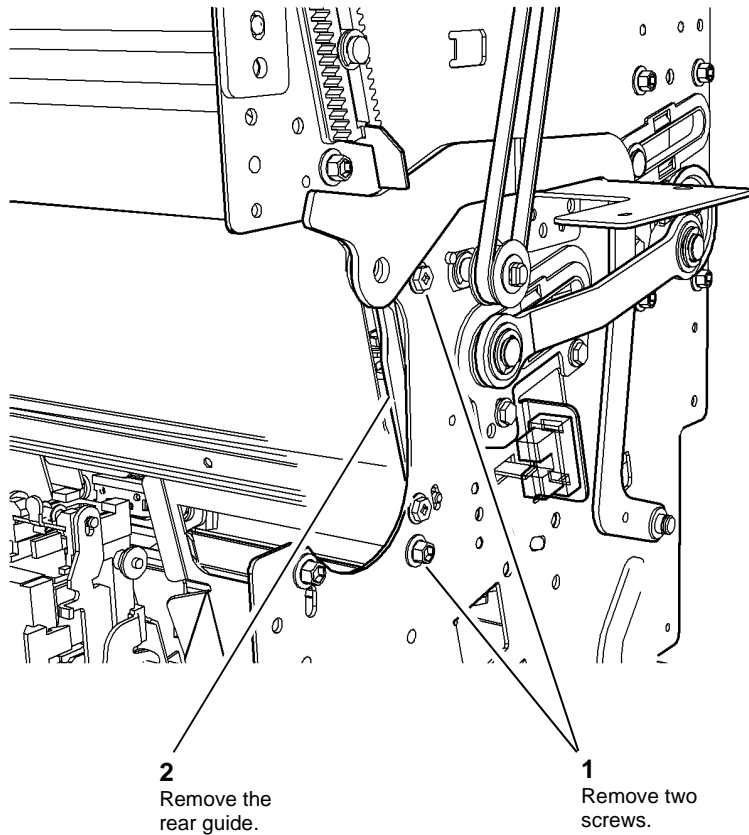
12. Figure 5, remove the grease roll gate rear guide.

Figure 5 Rear guide removal

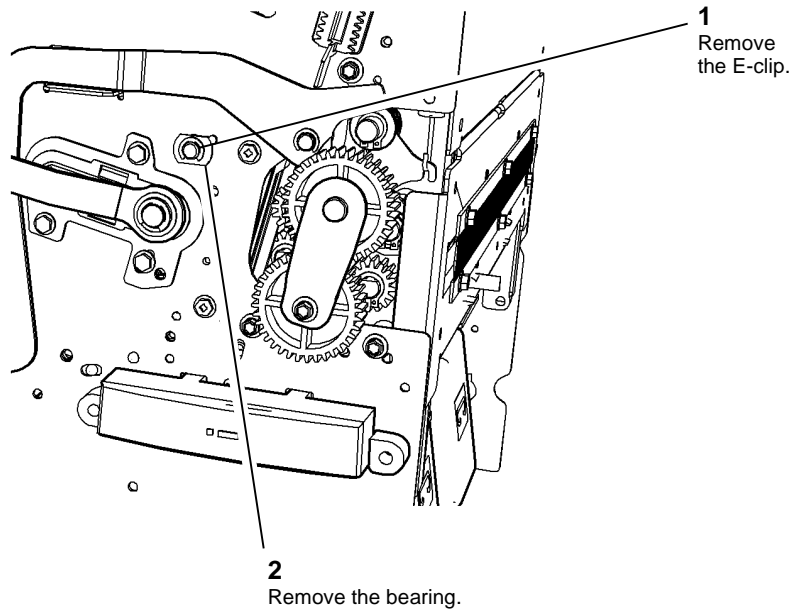
X-1-0526-A

6. Figure 1, remove the front bearing.

Figure 1 Front bearing removal

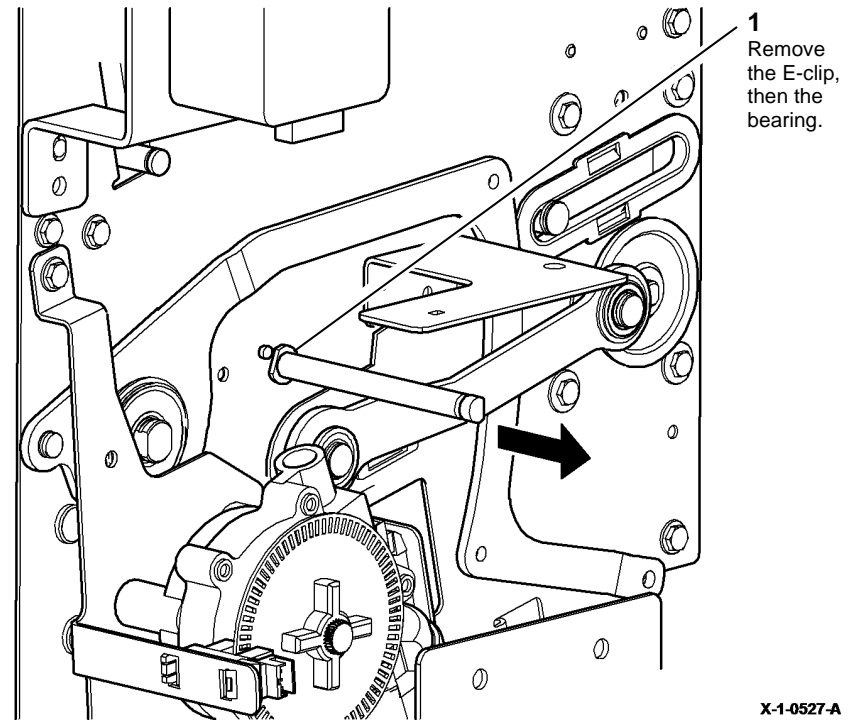
X-1-0527-A

7. Figure 2, remove the rear bearing.

Figure 2 Rear bearing removal

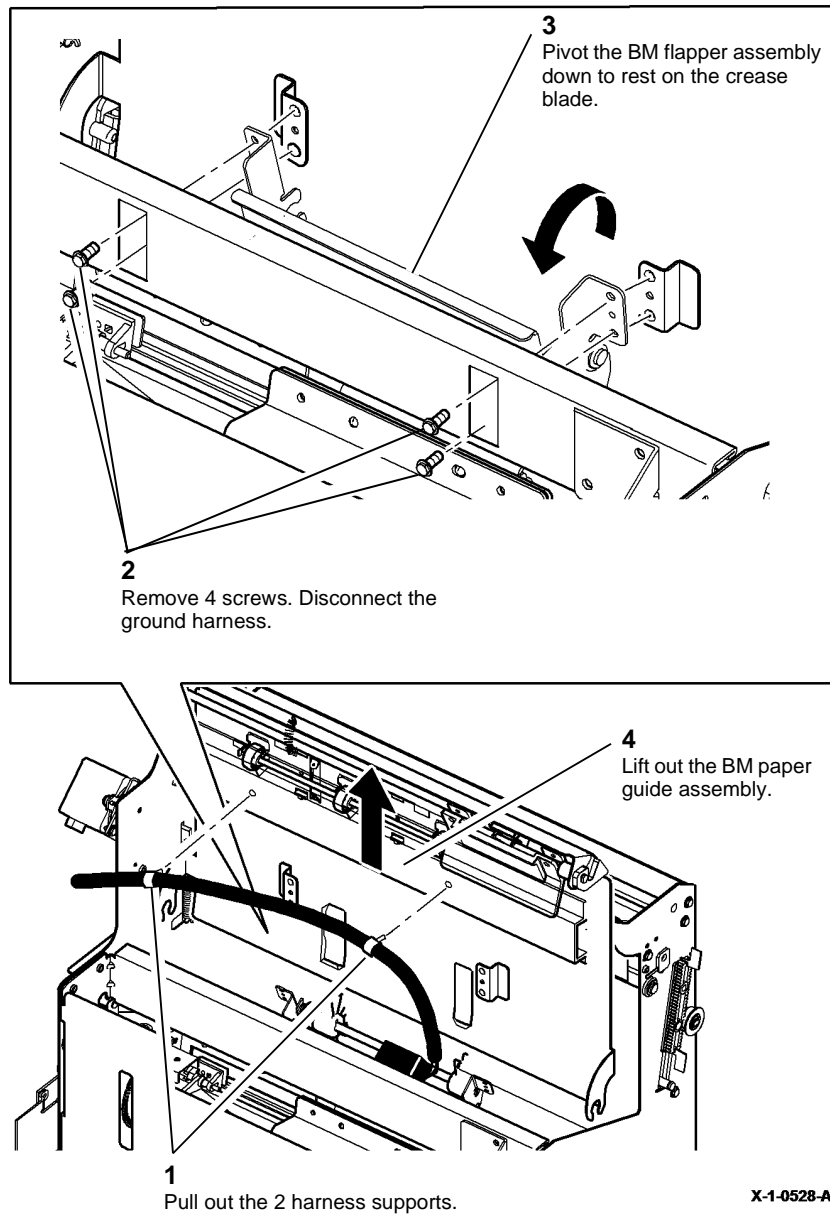
8. **Figure 3**, remove the BM paper guide assembly.

Figure 3 Paper guide assembly removal

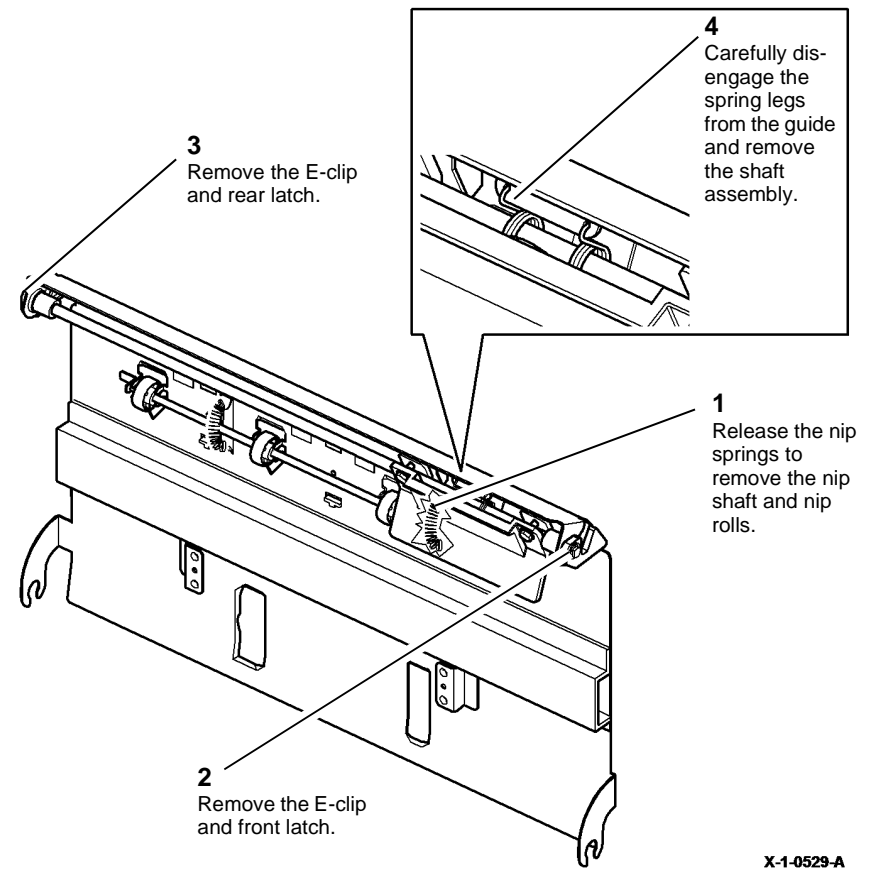
9. **Figure 4**, remove the components from the BM paper guide assembly.

Figure 4 Paper guide dismantling

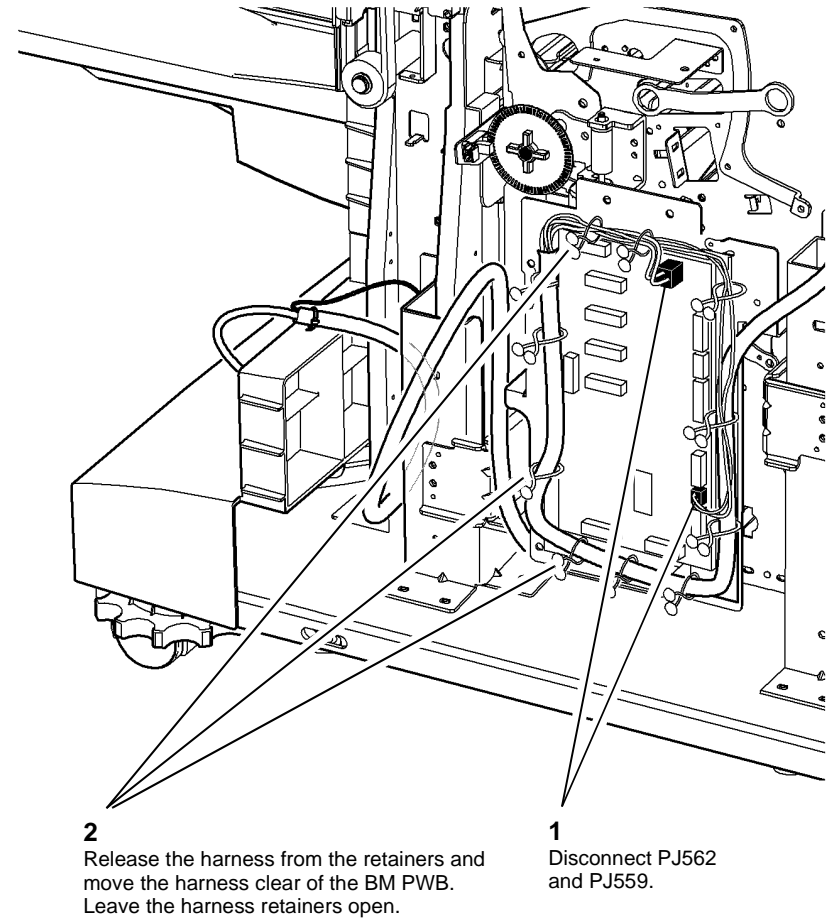
2. [Figure 1](#), disconnect PJ562 and PJ559 from the BM PWB.

2
Release the harness from the retainers and move the harness clear of the BM PWB. Leave the harness retainers open.

1
Disconnect PJ562 and PJ559.

Figure 1 Disconnect the PJs

4. Secure the harness to the BM PWB harness retainers, **Figure 1**. Use as many of the harness retainers as necessary to temporarily secure the bin 2 harness to the BM PWB so that the harness will not snag when the BM module is removed.

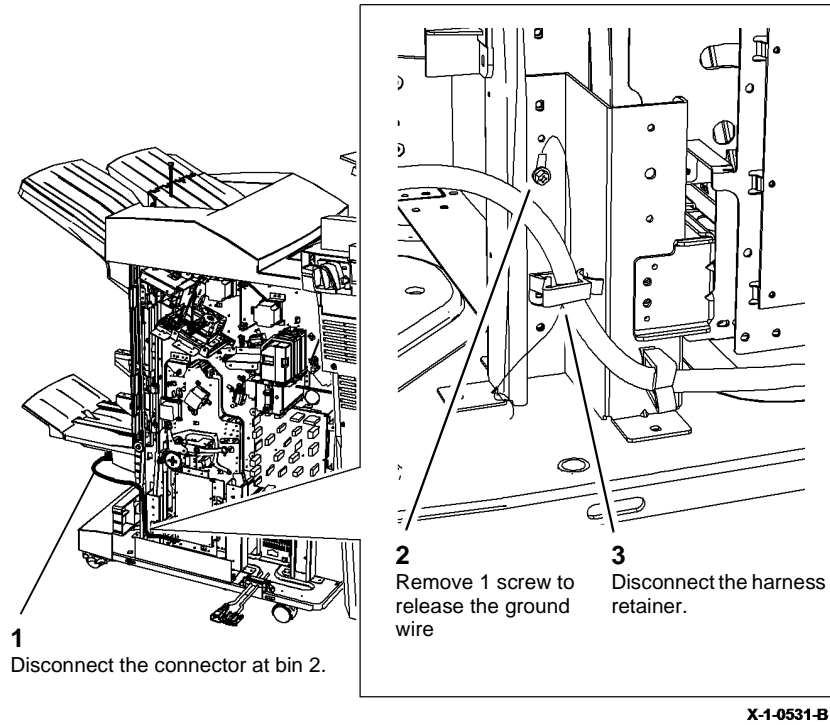
3. **Figure 2**, disconnect the harness from bin 2.

Figure 2 Disconnect the harness

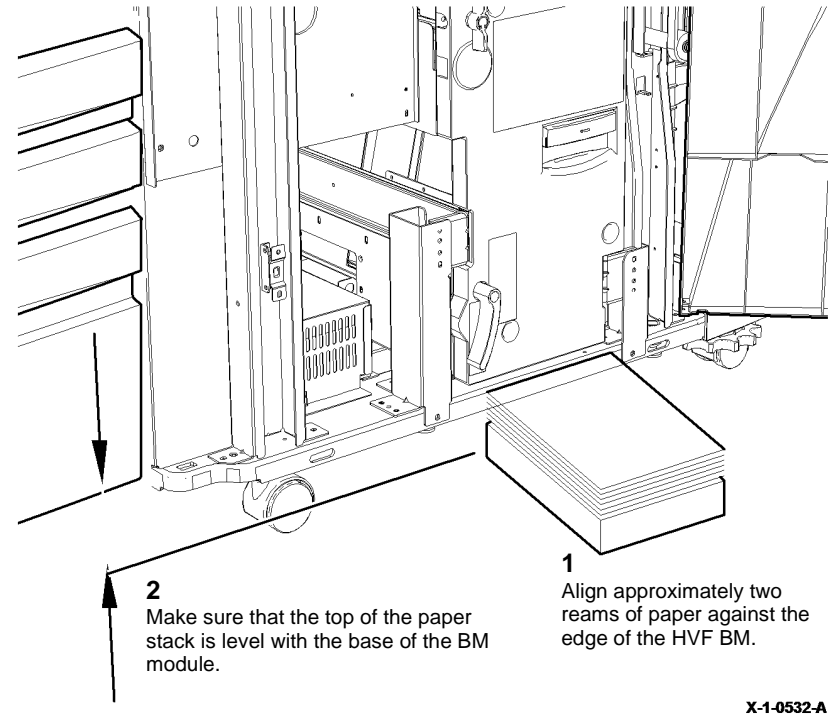
5. **Figure 3**, prepare to remove the BM module.

Figure 3 Preparation

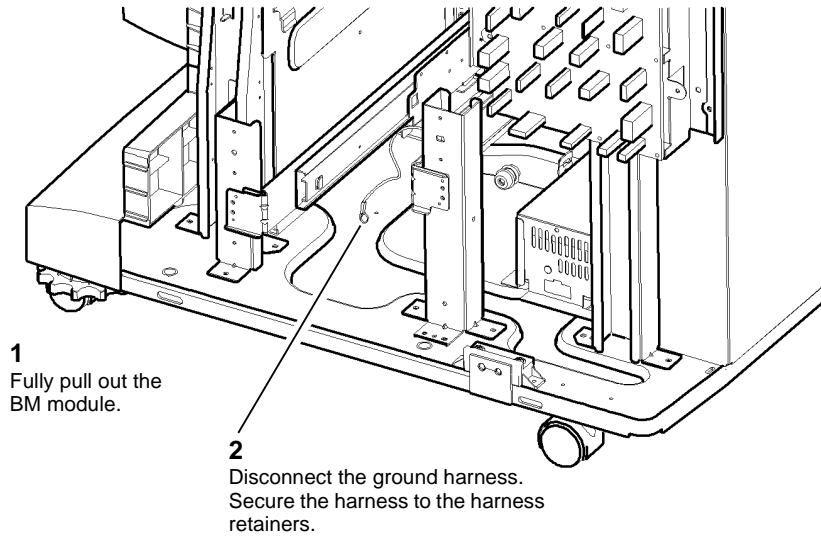
X-1-0533-A

6. **Figure 4**, prepare to remove the BM module.

Figure 4 Preparation

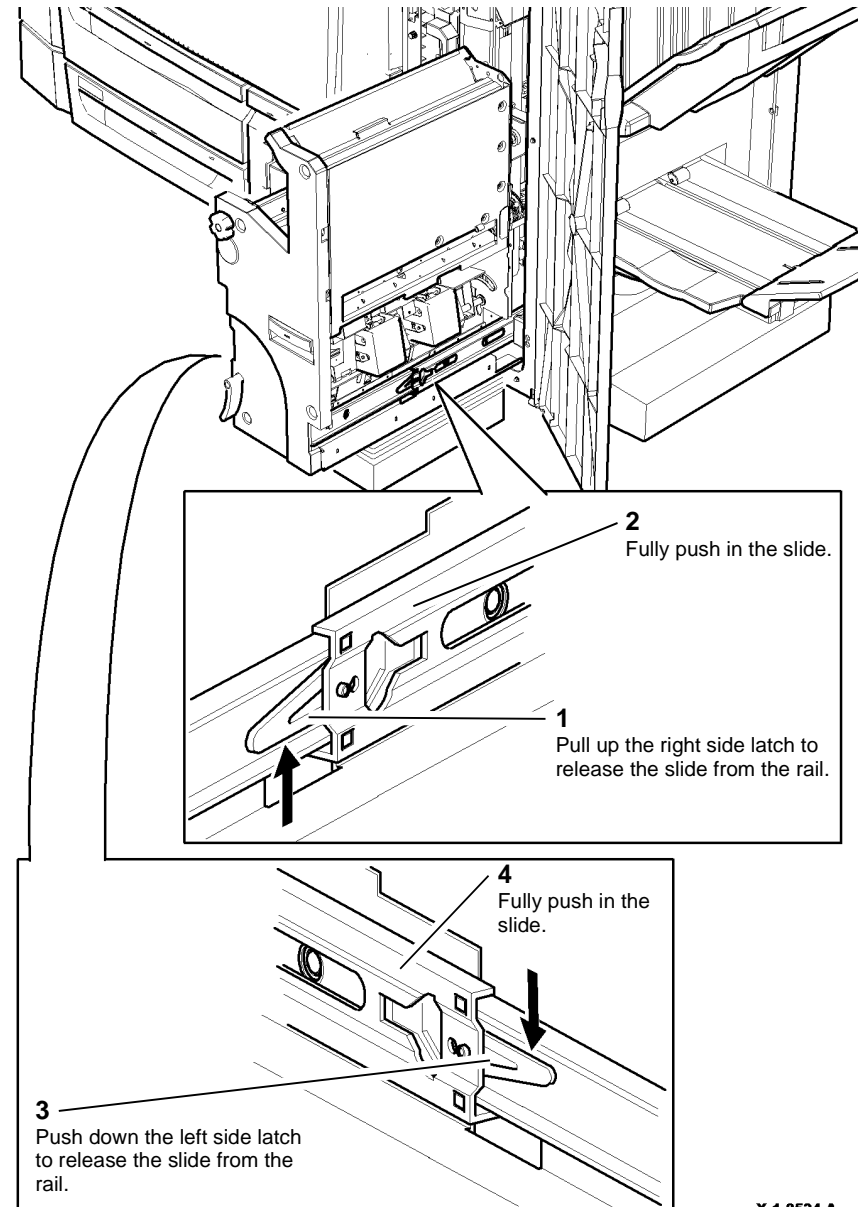
X-1-0534-A

7. **Figure 5**, Release the latches.

Figure 5 Releasing the latches

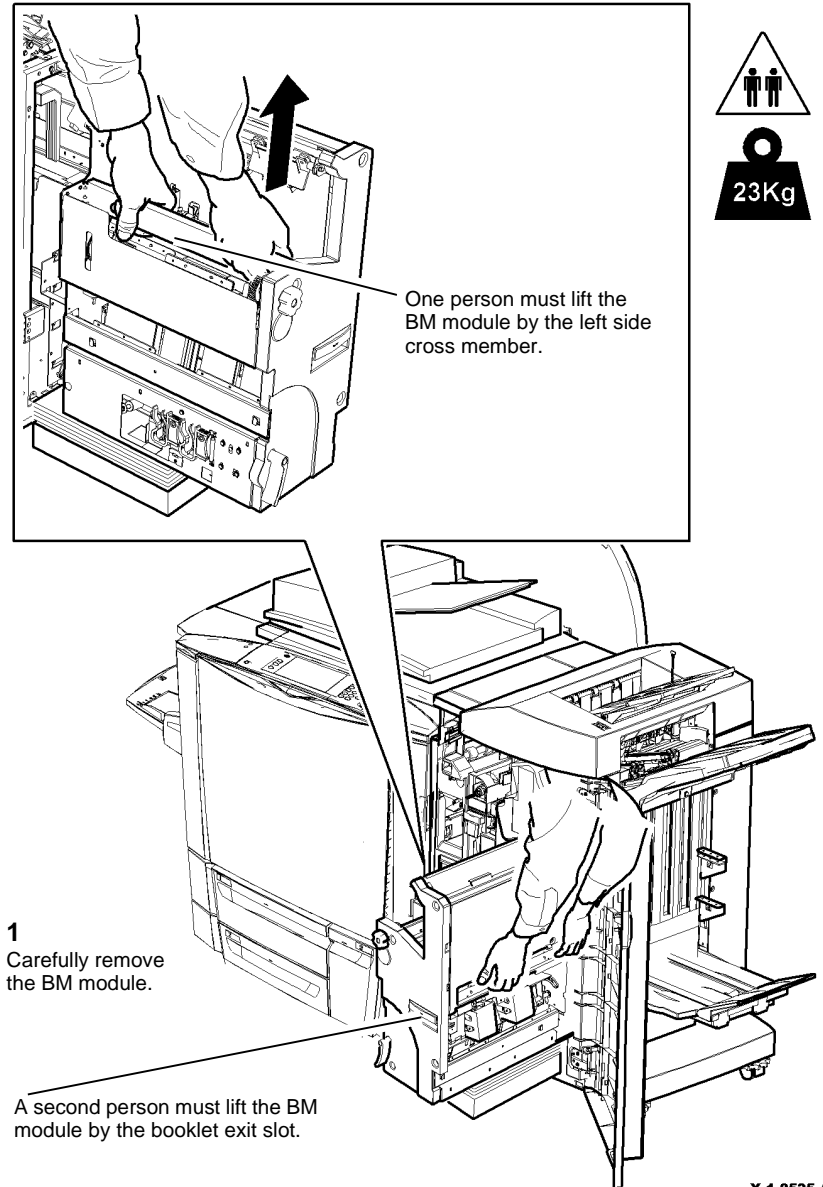
X-1-0535-A

8. **Figure 6**, remove the BM module.

Figure 6 Remove the BM module

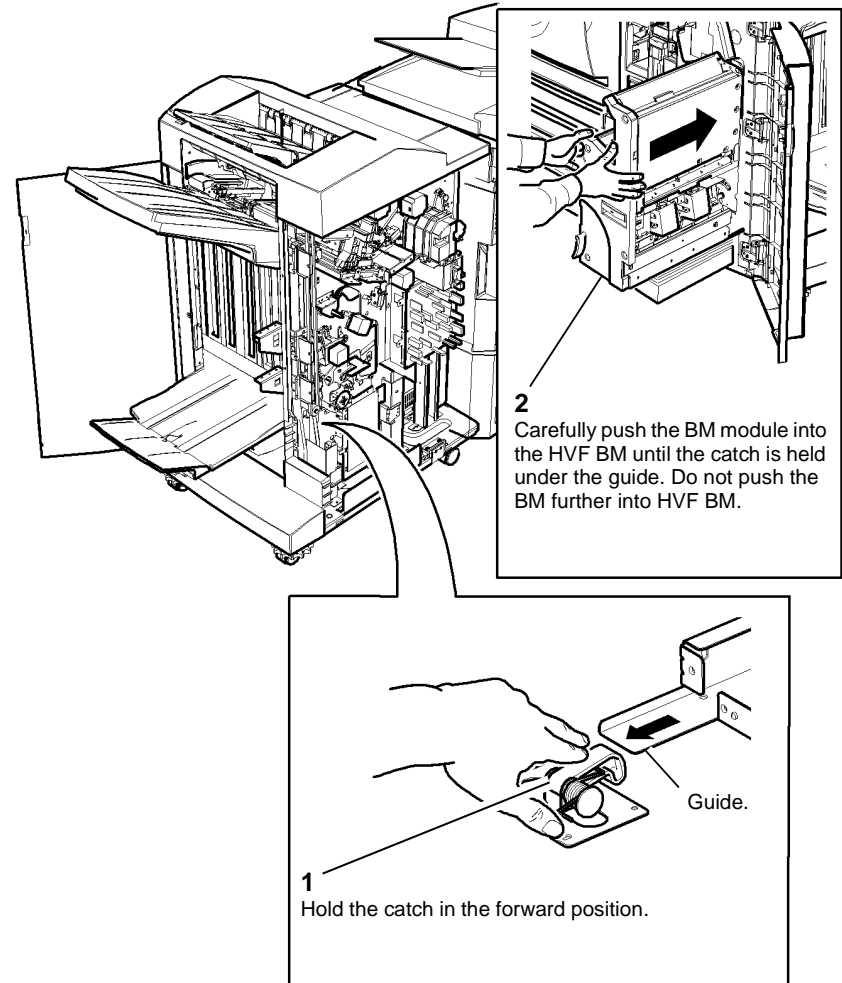
X-1-0536-A

1. Put the BM module on the paper stack in front of the HVF BM.
2. Ensure the bin 2 harness and the ground harnesses are secured to the BM PWB harness retainers, [Figure 1](#). Use as many of the harness retainers as necessary to temporarily secure the bin 2 harness to the BM PWB so that the harness will not snag when the BM module is installed.
3. If a new BM is to be installed, perform the following:
 - a. Unlatch the slides from the new BM module. Refer to [Figure 5](#).
 - b. Install the new BM module onto the existing rails in the HVF BM.
4. [Figure 7](#), prepare to install the BM module.

Figure 7 Position of the catch

NOTE: The BM catch will spring to the rear when the BM module is removed. Refer to **Figure 7**.

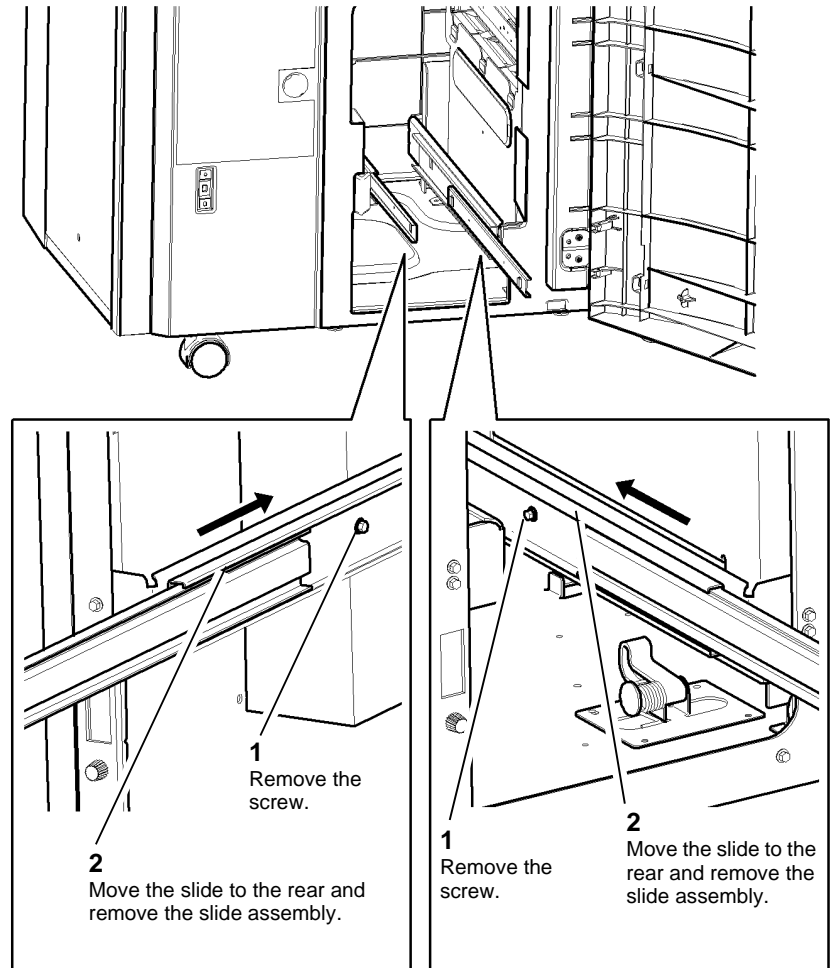
X-1-0537-A

3. [Figure 1](#), Remove the slide assemblies from the HVF BM frame.

Figure 1 Slide assembly removal

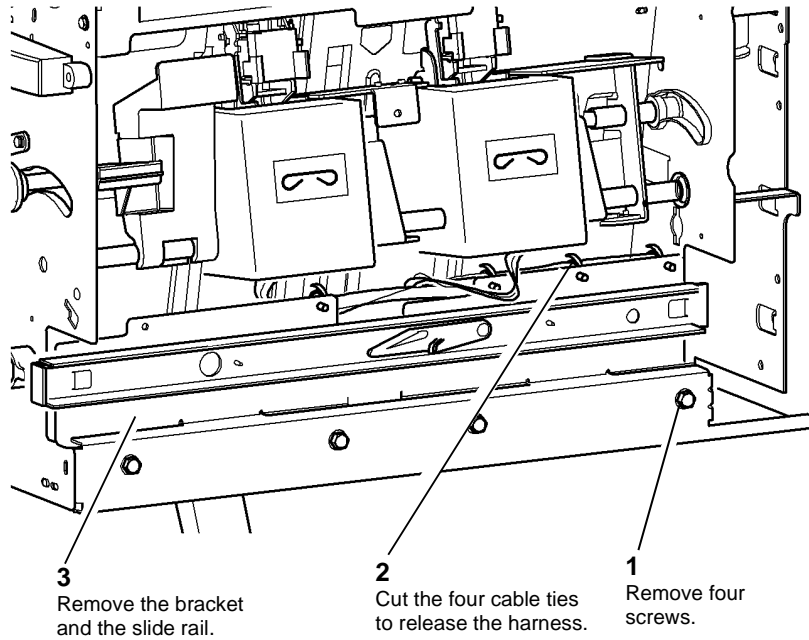
X-1-0538-A

4. **Figure 2.** Remove the bracket and the slide rail from the right side of the BM module.

Figure 2 Bracket and rail removal

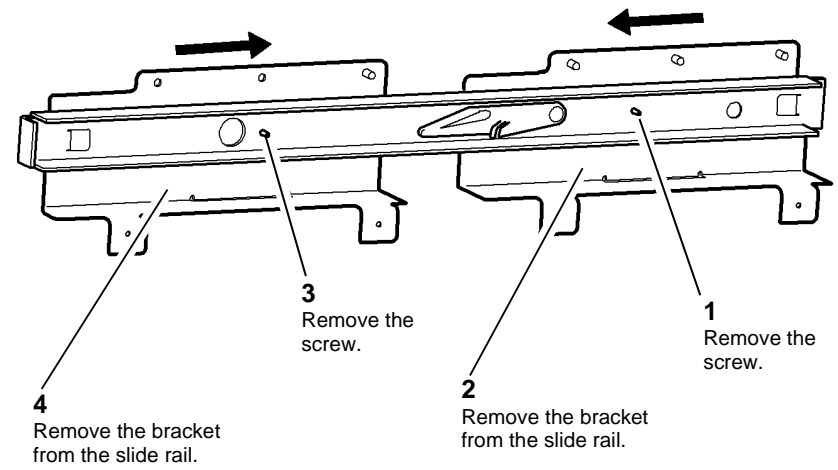
X-1-0539-A

5. **Figure 3.** Remove the two brackets from the slide rail.

Figure 3 Bracket removal

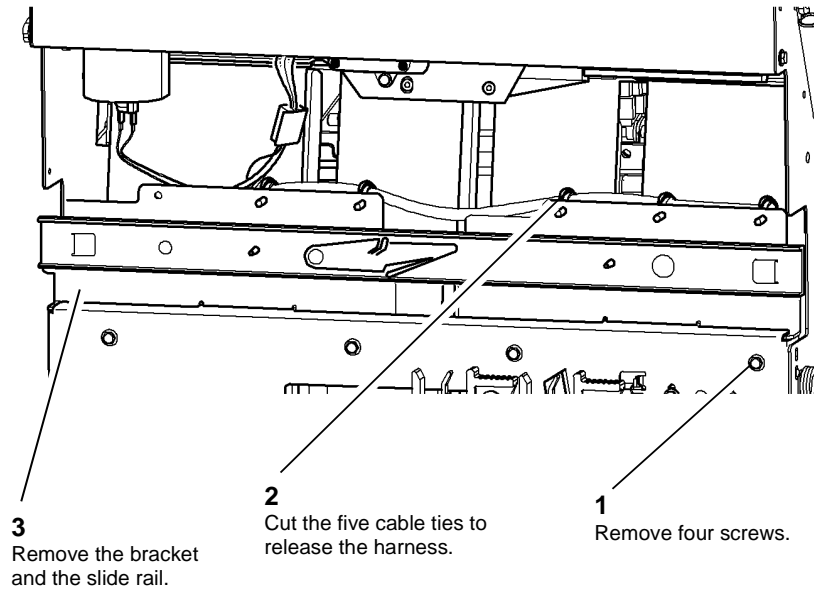
X-1-0540-A

6. **Figure 4**, Remove the bracket and the slide rail from the left side of the BM module.

Figure 4 Bracket and rail removal
