708P91368
September 2017

Xerox® AltaLink® B8090 Family Multifunction Printer Service Manual

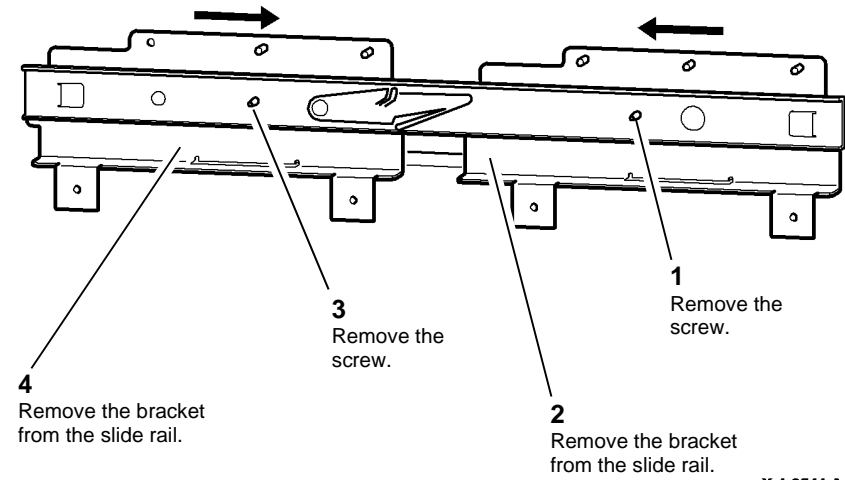
X-1-0541-A

7. **Figure 5**, Remove the two brackets from the slide rail

Figure 5 Bracket removal

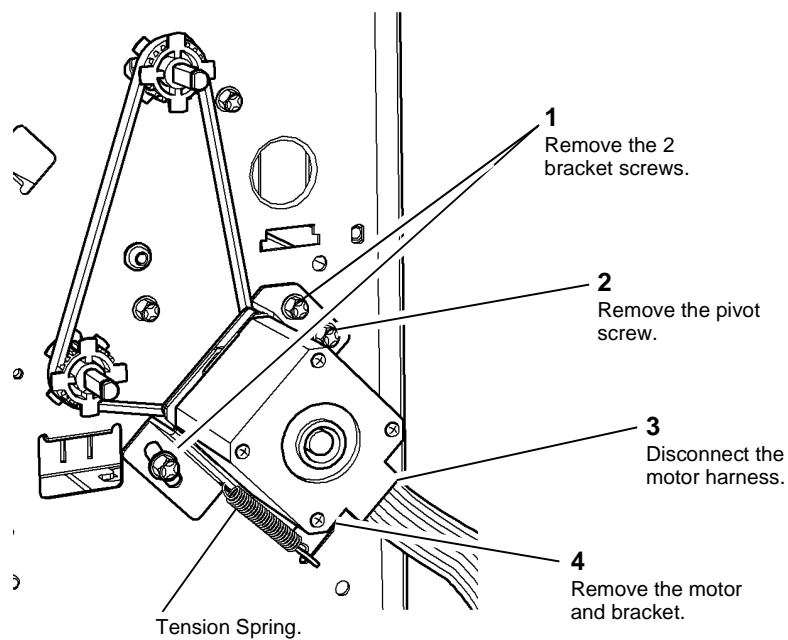
X-1-0542-A

1. Remove the rear cover [REP 12.1-171](#).
2. Remove the transport motor 1 and bracket assembly, [Figure 1](#).

Figure 1 Motor and bracket removal

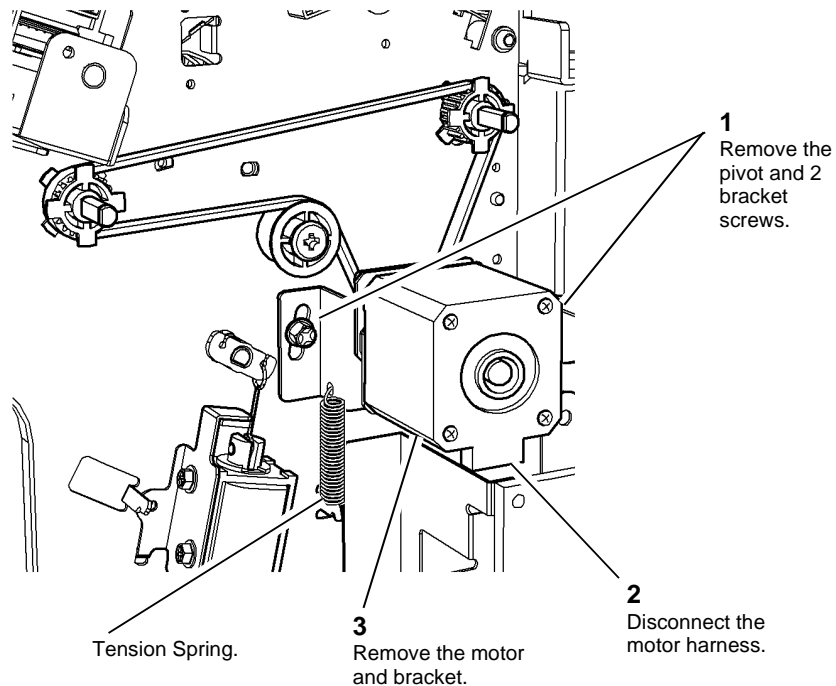
X-1-0543-A

1. Remove the rear cover [REP 12.1-171](#).
2. Remove the bypass feed motor and bracket assembly, [Figure 1](#).

Figure 1 Motor and bracket removal

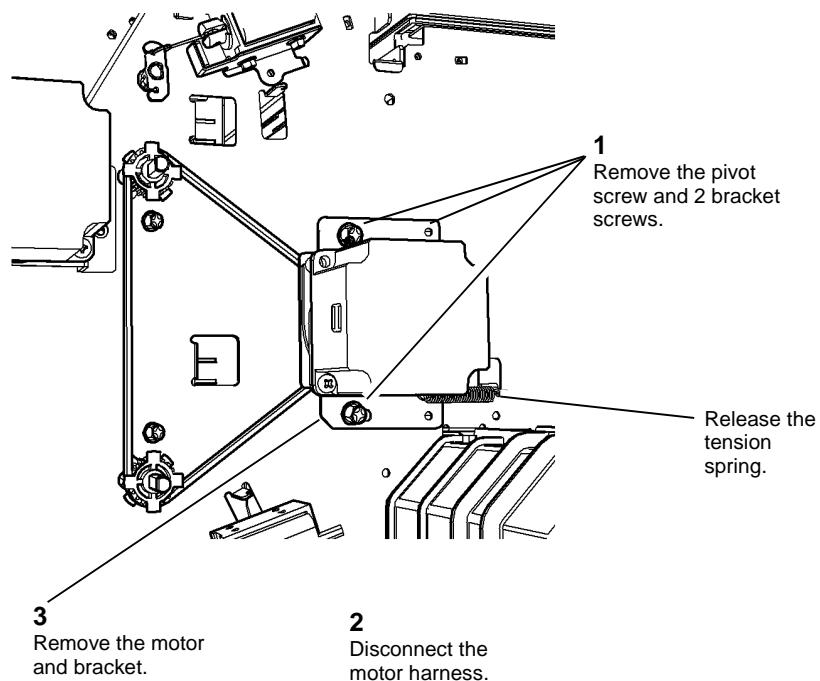
X-1-0544-A

1. Remove the rear cover [REP 12.1-171](#).
2. Remove the buffer feed motor and bracket assembly, [Figure 1](#).

Figure 1 Motor and bracket removal

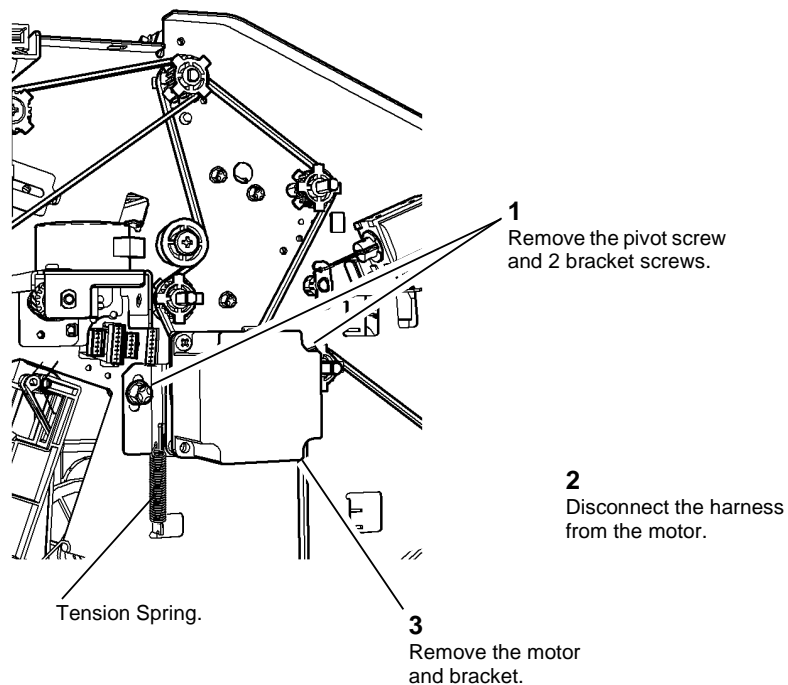
X-10545-A

1. Remove the rear cover [REP 12.1-171](#).
2. Remove the transport motor 2 and bracket assembly, [Figure 1](#).

Figure 1 Motor and bracket removal

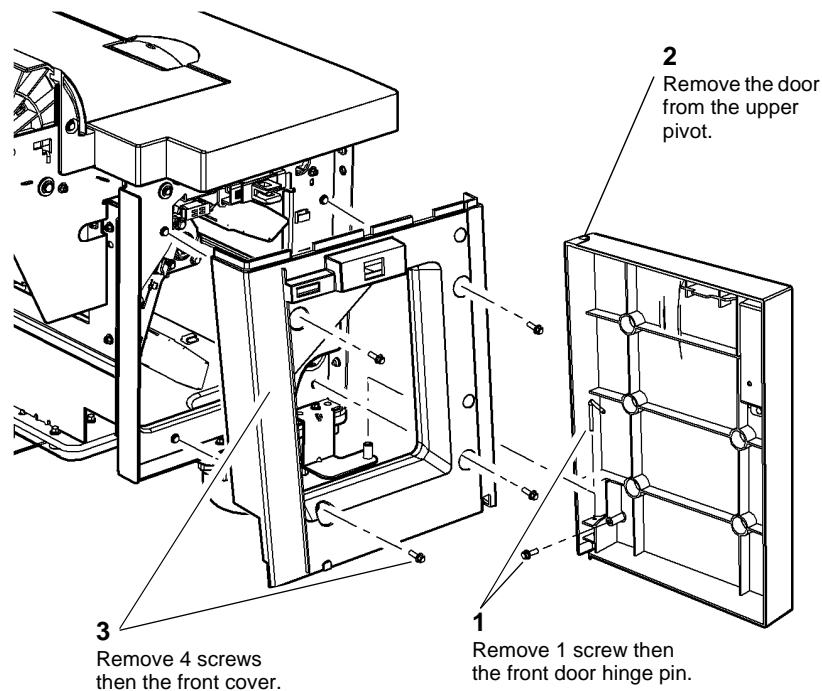
X-1-0546-A

1. Remove the front door and the front cover as required, [Figure 1](#).

Figure 1 Door and cover removal

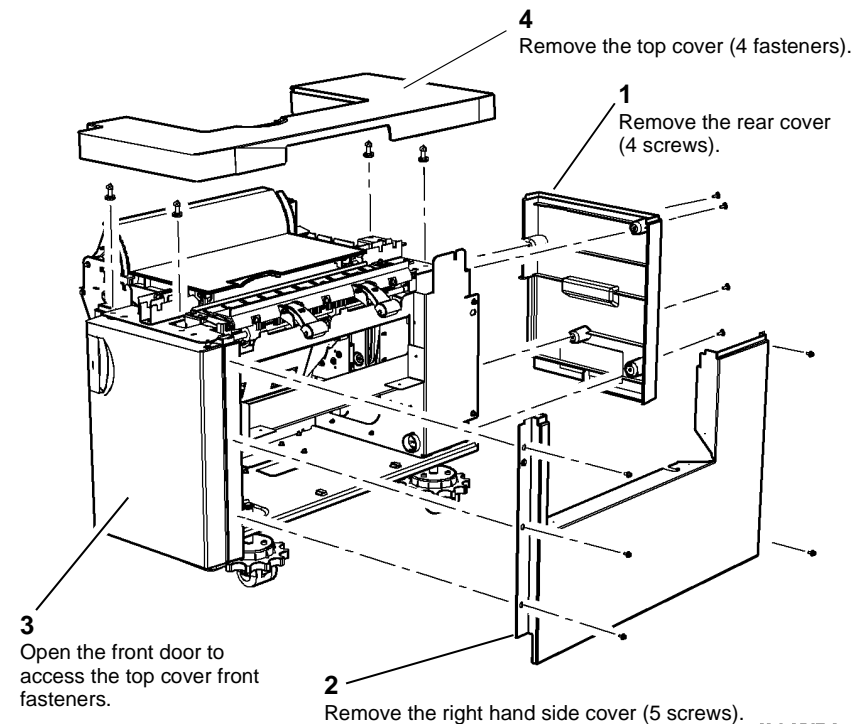
X-1-0547-A

2. Remove the rear cover, the top cover and the right side cover as required, [Figure 2](#).

NOTE: Open the top cover and remove the rear cover to access to the top cover rear fasteners and the top cover interlock sensor connector.

Figure 2 Covers removal

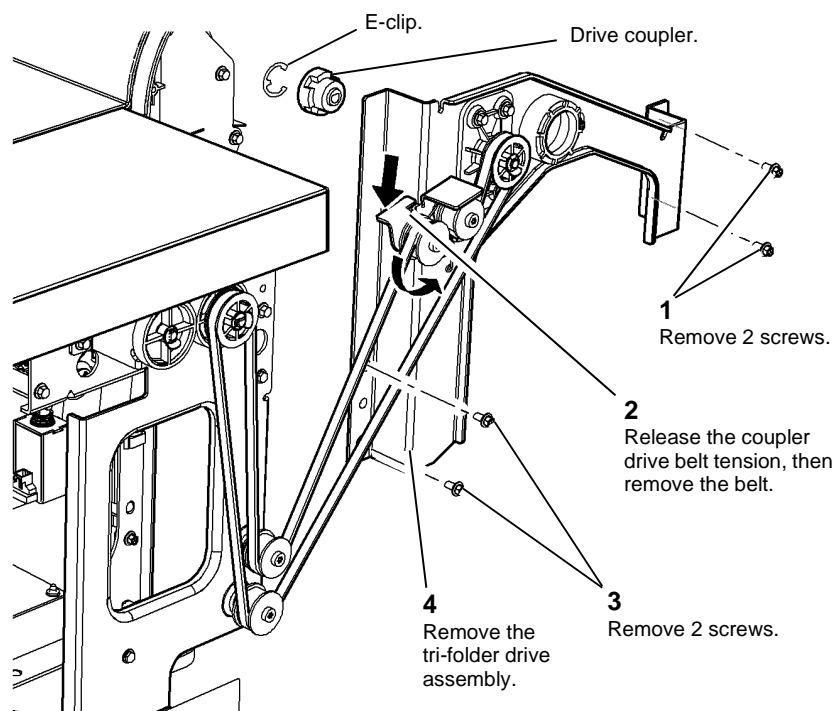
X-1-0548-A

1. Remove the HVF rear cover, [REP 12.1-171](#).
2. Remove the tri-folder rear cover [REP 12.67-171](#).
3. Remove the tri-folder drive assembly, [Figure 1](#).

Figure 1 Drive assembly removal

1. Detach the coupler alignment tool from the drive unit, refer to [Figure 1](#).
2. Install the drive assembly, [Figure 2](#).

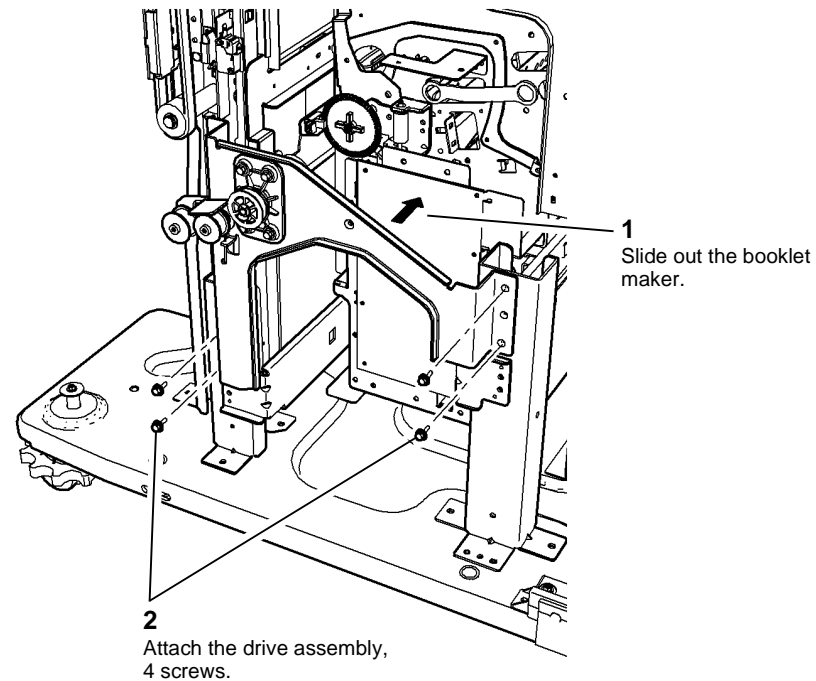
X-1-0549-A

Figure 2 Drive assembly install

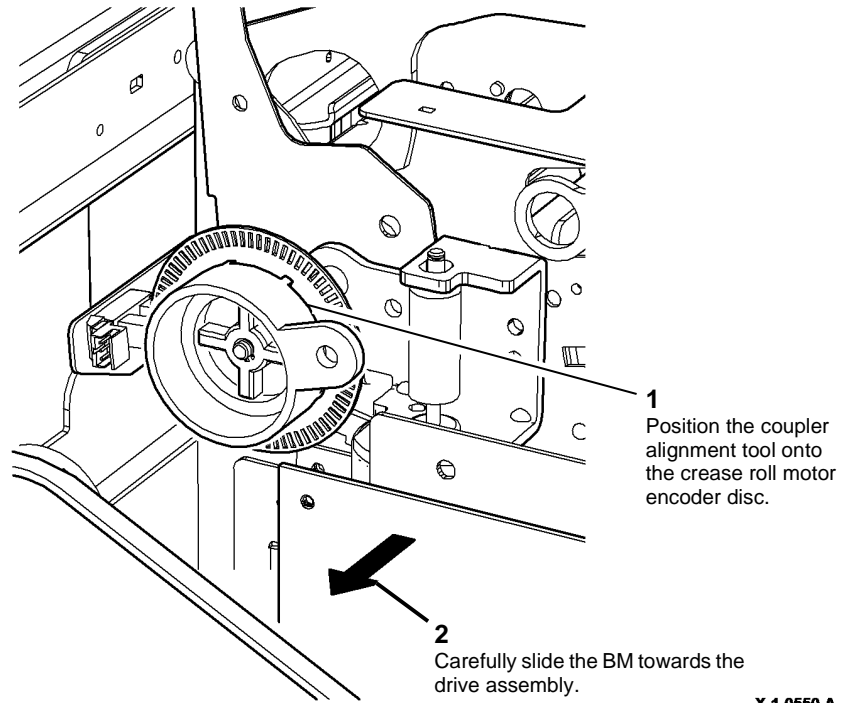
3. Centralize the coupler alignment tool onto the crease roll motor encoder disc, [PL 12.175 Item 13](#) and [Figure 3](#).
5. Loosen the drive unit retaining screws, [Figure 4](#).

Figure 3 Alignment tool positioning

4. Prepare to centralize the drive coupler, refer to [Figure 1](#), with the HVF BM crease roll motor encoder disc, [Figure 3](#).

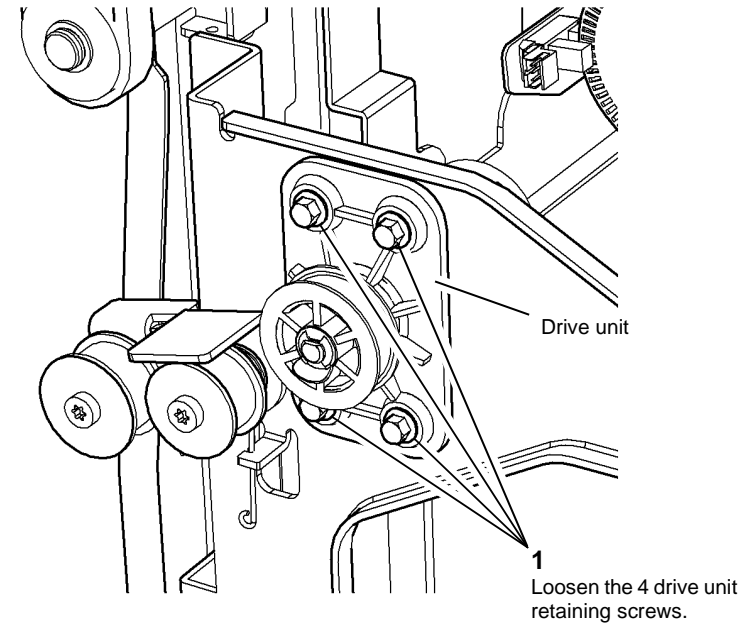
X-1-0551-A

Figure 4 Drive unit preparation

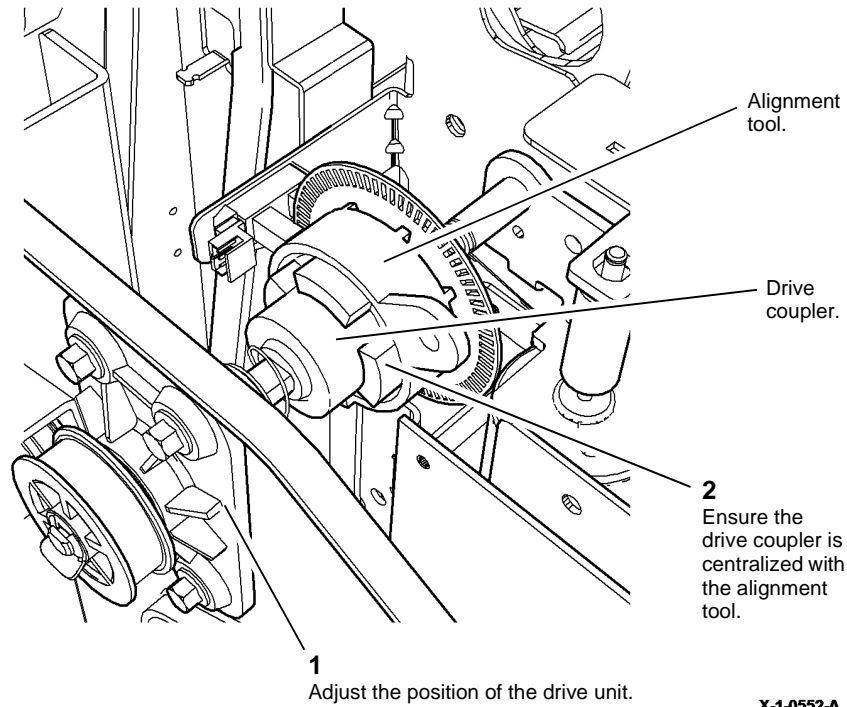
6. Centralize the coupler alignment tool with the drive unit coupler, [Figure 5](#).

Figure 5 Drive coupler positioning

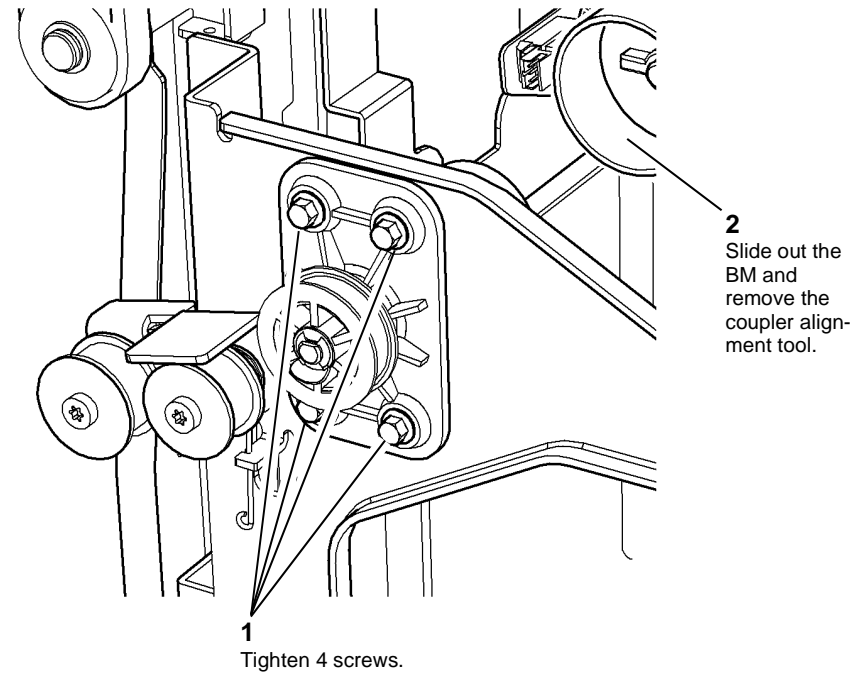
7. Secure the drive unit in the centralized position, [Figure 6](#).

Figure 6 Secure the drive unit

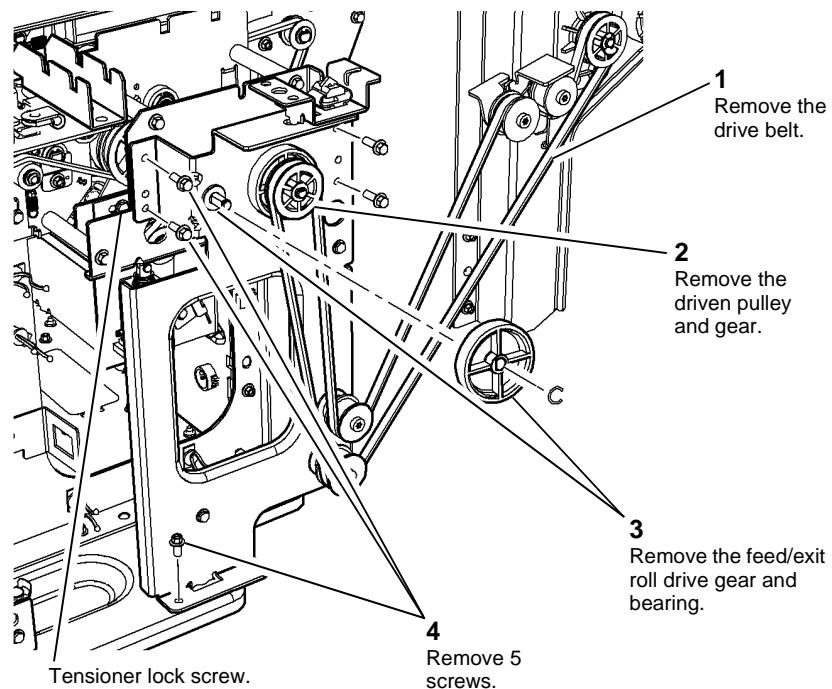
1. Remove the Tri-folder rear cover, [REP 12.67-171](#). Access is improved by removing the top cover.
2. Remove the drive coupling assembly bracket, [Figure 1](#).

Figure 1 Bracket removal

3. Slacken the tensioner lock screw and move the crease roll tensioner pulley to the left, then tighten the lock screw, [Figure 1](#).

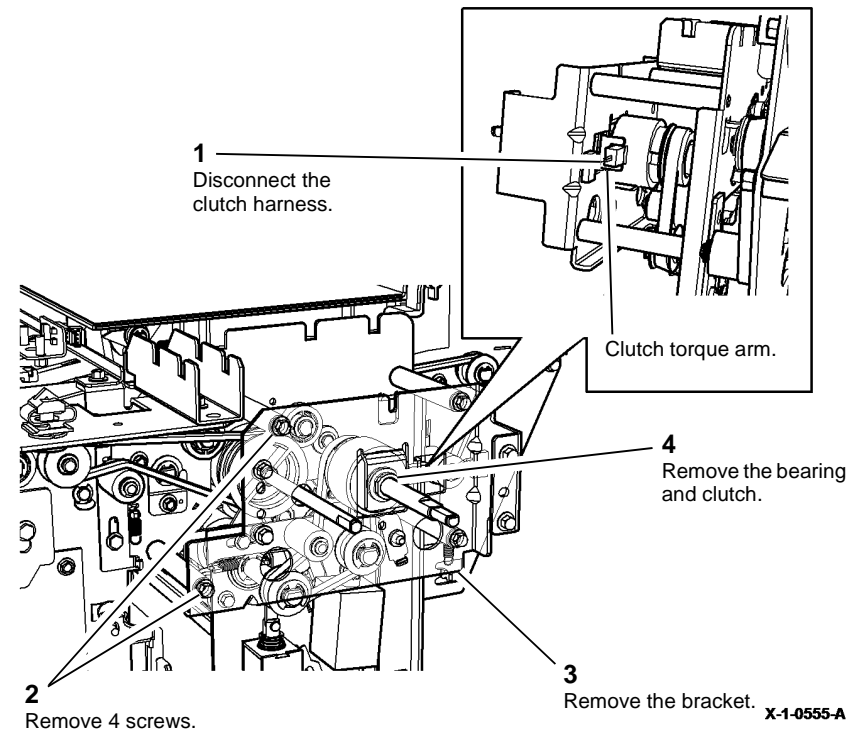
4. Remove the clutch and bearing from the idler assembly bracket, [Figure 2](#).

Figure 2 Clutch and bearing removal

1. Reverse the removal procedures to reinstall the crease roll clutch and drive coupling assembly.
2. Replace the idler assembly with the smooth side of the crease roll drive belt towards the idler, then fit the drive belt over the clutch pulley, [Figure 2](#).
3. Position the clutch torque arm in the slot in the idler bracket, See [Figure 2](#) insert.
4. Perform [ADJ 12.10-171](#) Motor Drive Belt Tensioning.

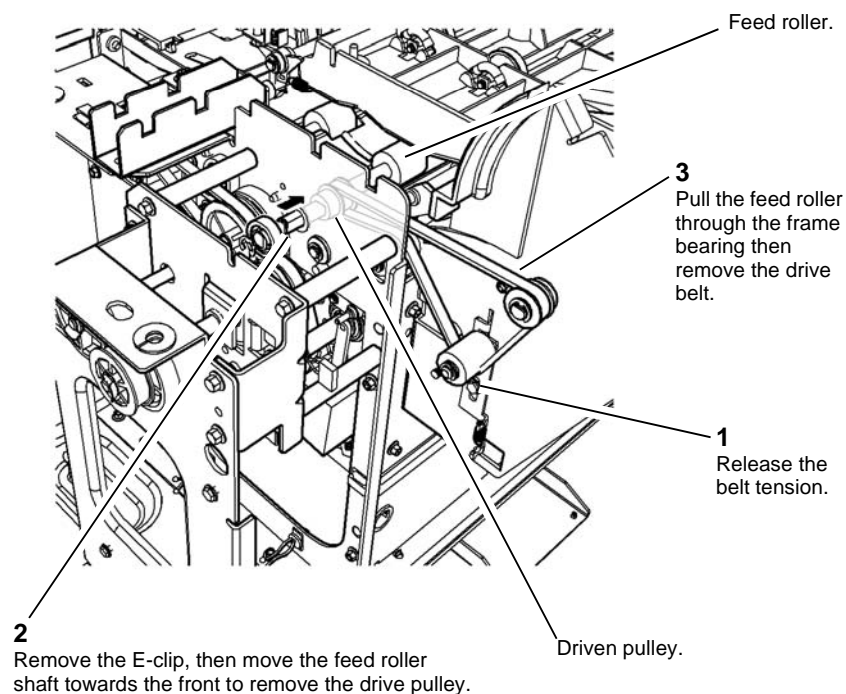
X-1-0556-A

1. Un-dock the tri-folder from the HVF and move the unit to the right to access the left side of the frame, [REP 12.99-171](#).
2. Remove the drive belt, [Figure 1](#).

Figure 1 Feed roller and drive belt

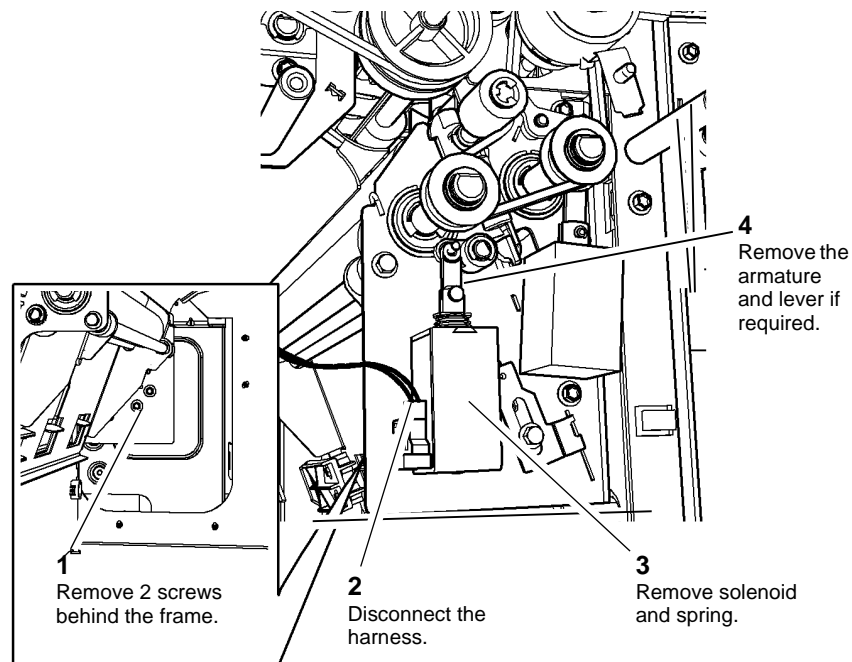
1. Open the tri-folder front door, or remove the bin 2 assembly, then remove the tri-folder rear cover, [REP 12.67-171](#).
2. Remove the assist gate solenoid, [Figure 1](#).

Figure 1 Solenoid removal

1. Reverse the removal procedures to replace the assist gate solenoid.
2. Refit the armature and lever before replacing the spring and solenoid coil. If necessary, get assistance to hold the armature coil in position when replacing the screws.

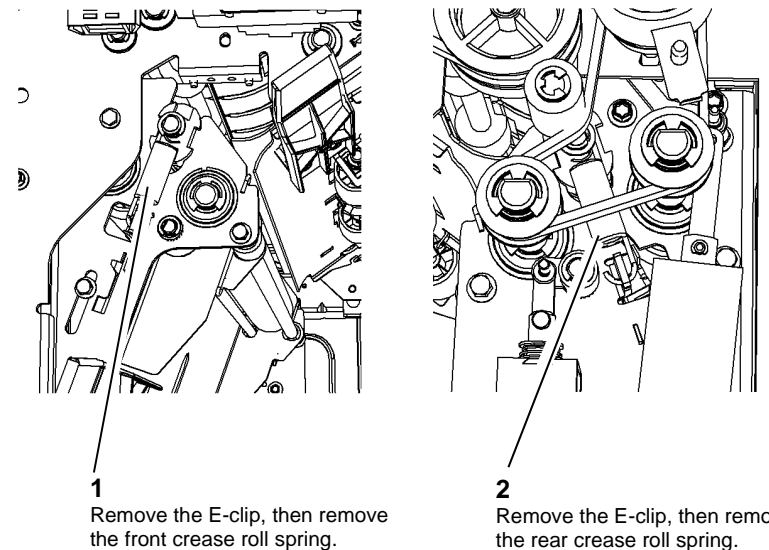
1. Remove the tri-folder front door, front cover and rear cover [REP 12.67-171](#).
2. Remove the front or rear spring, [Figure 1](#).

Figure 1 Crease roll springs removal

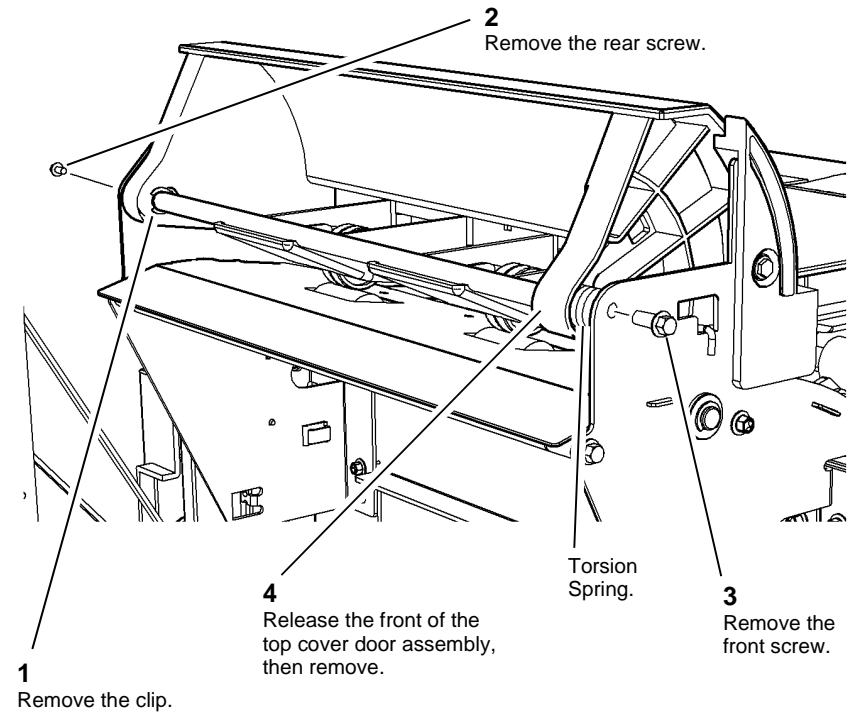
X-1-0559-A

2. Remove the top cover door assembly, [Figure 1](#).

NOTE: Control the movement of the torsion spring.

Figure 1 Top cover removal

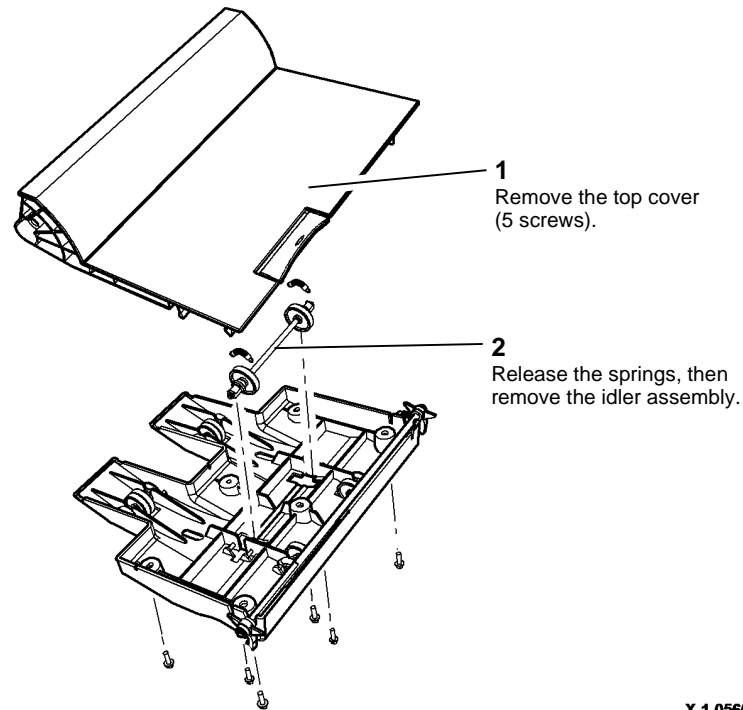
X-1-0560-A

3. Remove the idler assemblies, [Figure 2](#).

Figure 2 Idler assembly removal

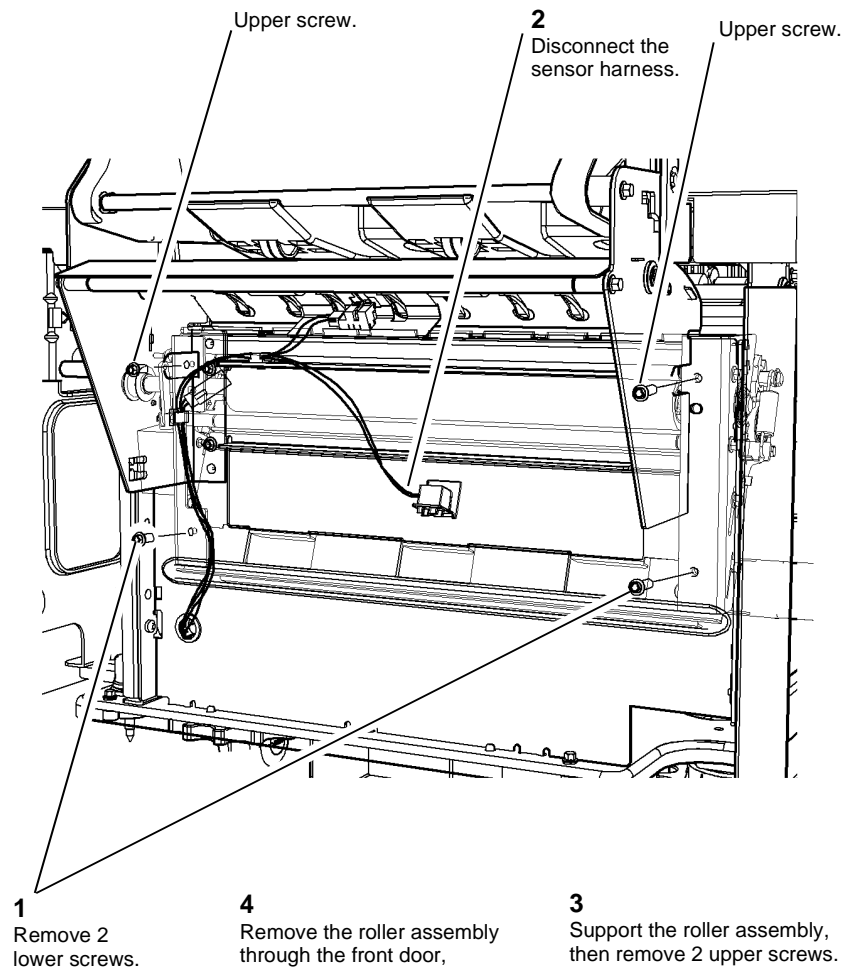
X-1-0561-A

- Remove the roller assembly [Figure 1](#).

Figure 1 Roller assembly removal

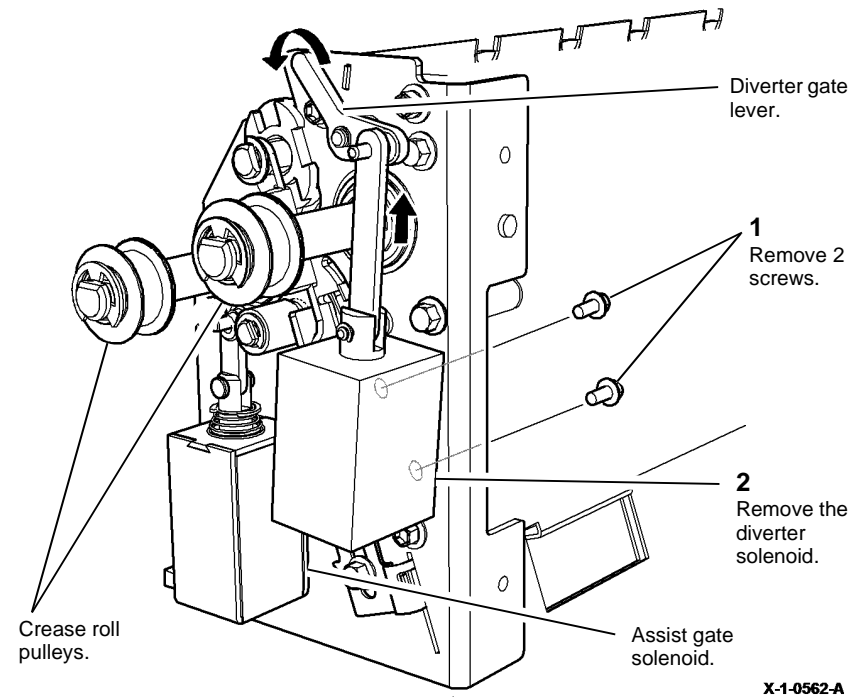
X-1-0562-A

- Remove the diverter gate solenoid and crease roll pulleys as required, [Figure 2](#).

Figure 2 Solenoid removal

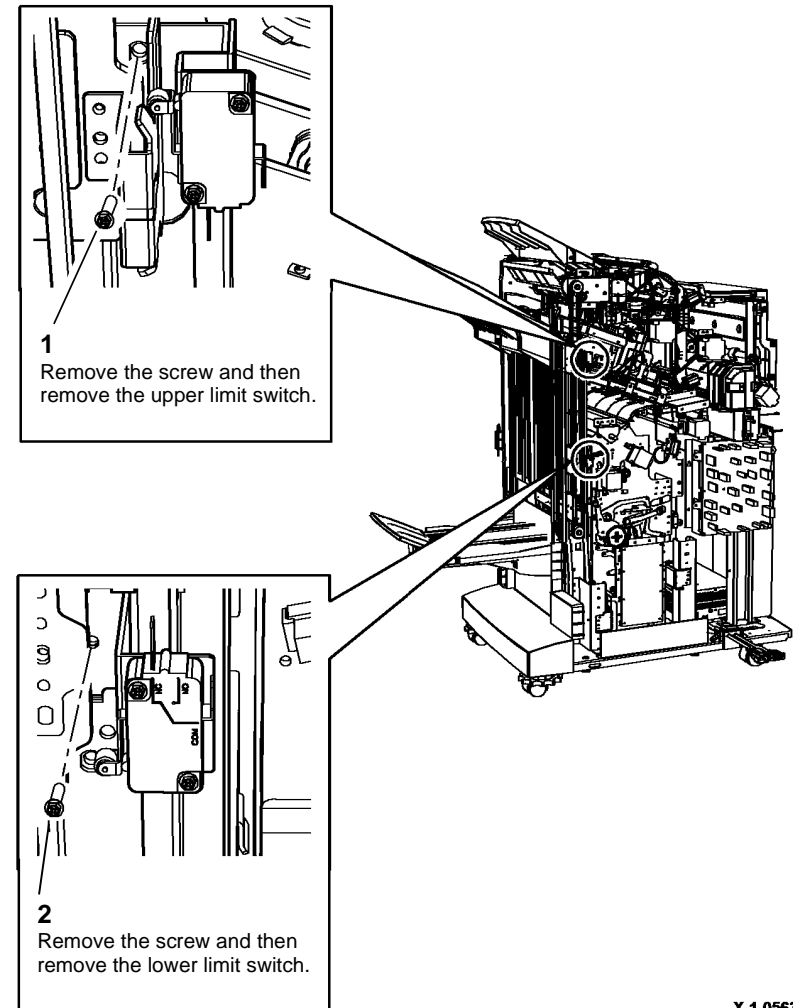
X-1-0563-A

1. Remove the HVF rear cover, [REP 12.1-171](#).
2. Disconnect the PJs and remove the upper or lower limit switch and bracket as required, [Figure 1](#).

Figure 1 Switches removal

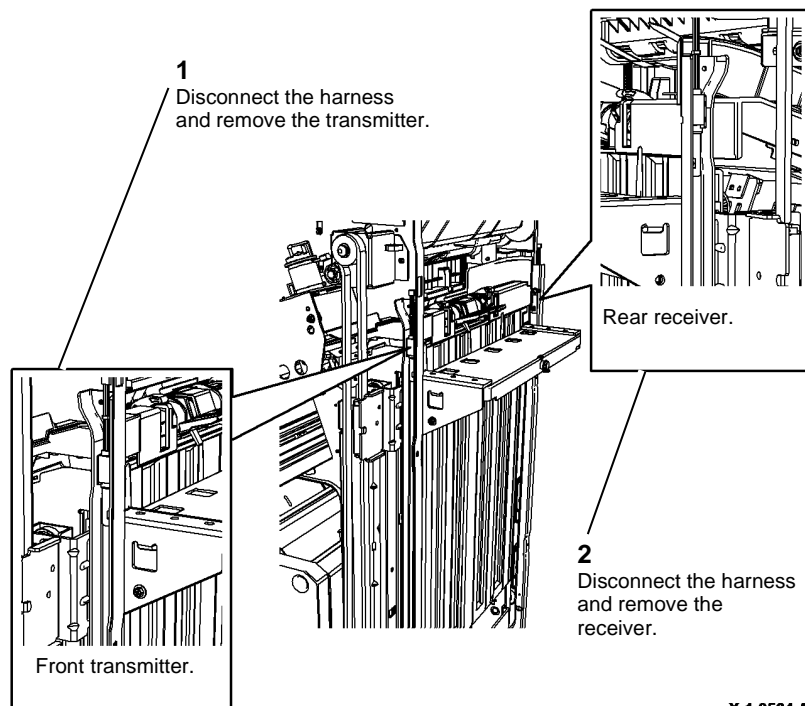
1. Remove the HVF front and rear covers, [REP 12.1-171](#).
2. Remove the receiver or transmitter as necessary, [Figure 1](#).

Figure 1 Sensor removal

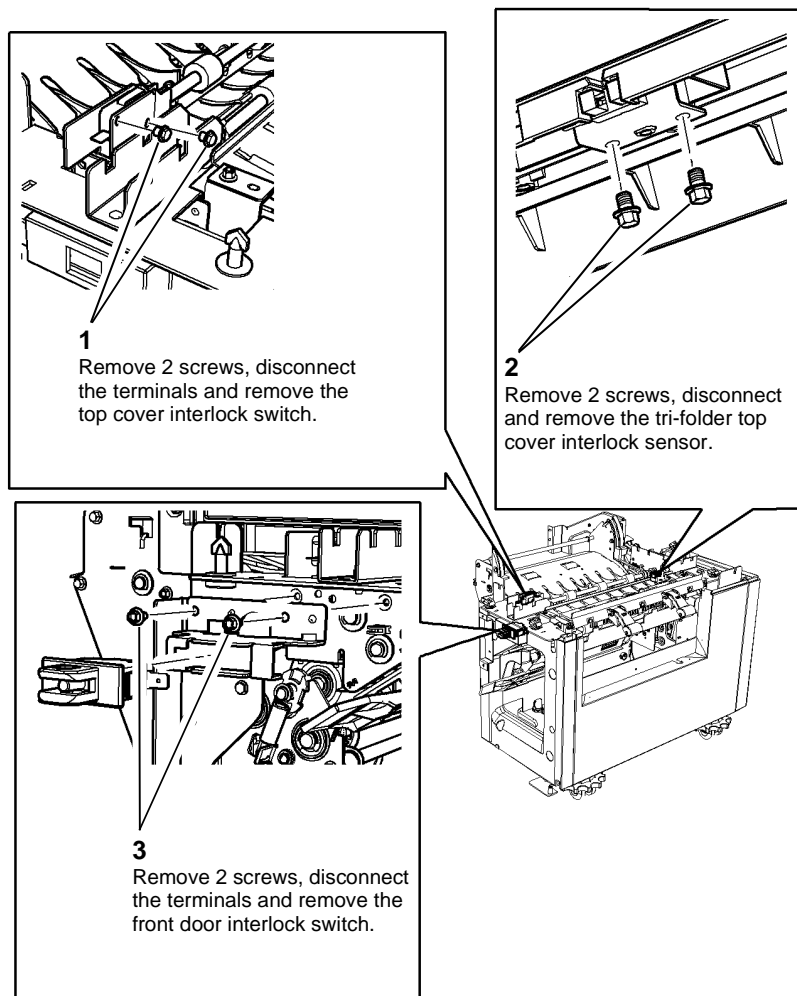
X-1-0565-A

2. Remove the front door interlock switch, top cover interlock switch and the tri-folder top cover interlock sensor, as required, [Figure 1](#).

Figure 1 Switches and sensor removal

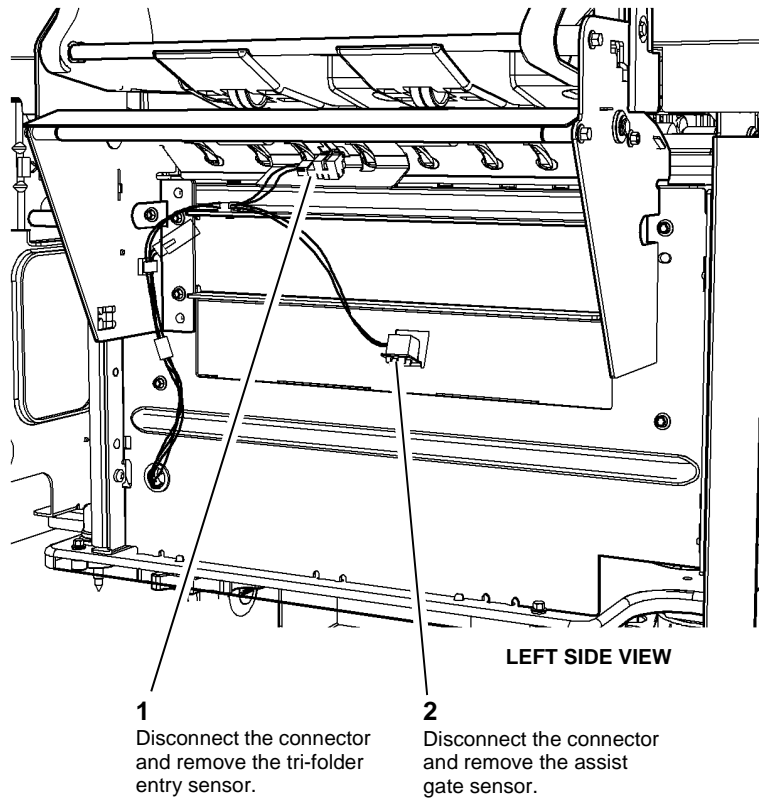
- Remove the tri-folder entry sensor and assist gate sensor, [Figure 1](#).

Figure 1 Sensors removal

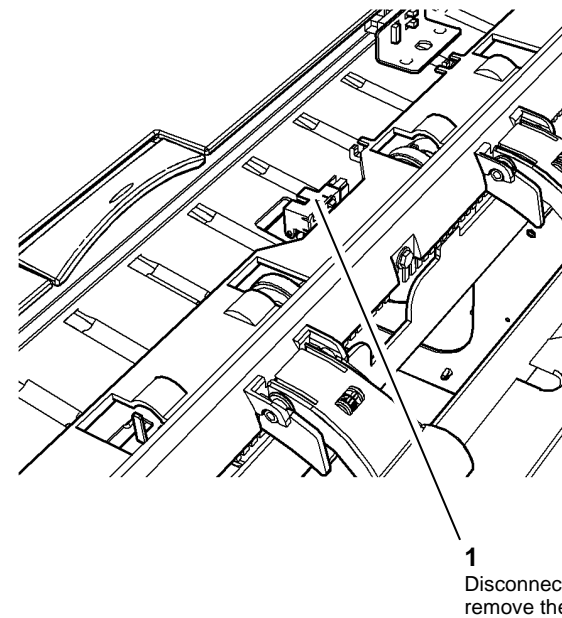
X-1-0567-A

- Remove the tri-folder top cover, [REP 12.67-171](#).
- Remove the exit sensor, [Figure 1](#).

- Disconnect the harness and remove the exit sensor.

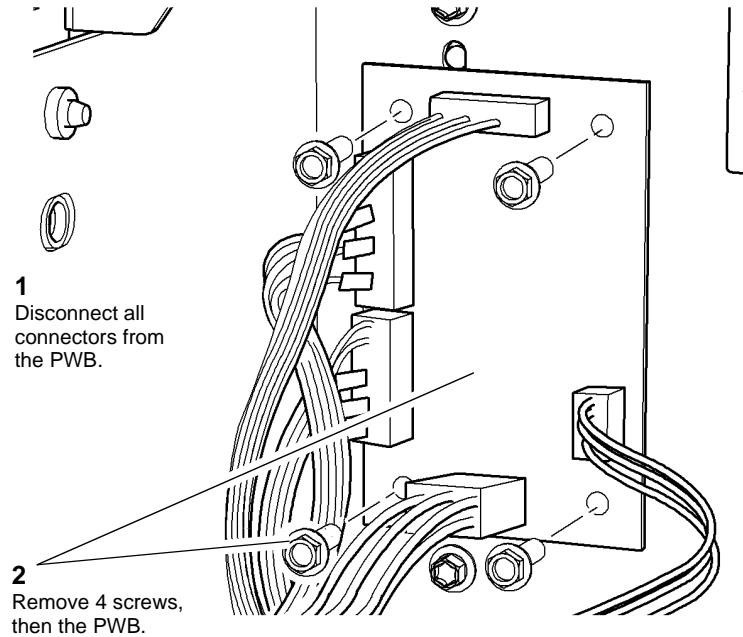
X-1-0568-A

1. Remove tri-folder rear cover, [REP 12.67-171](#).
2. Remove the tri-folder PWB, [Figure 2](#).

Figure 2 Tri-folder Control PWB

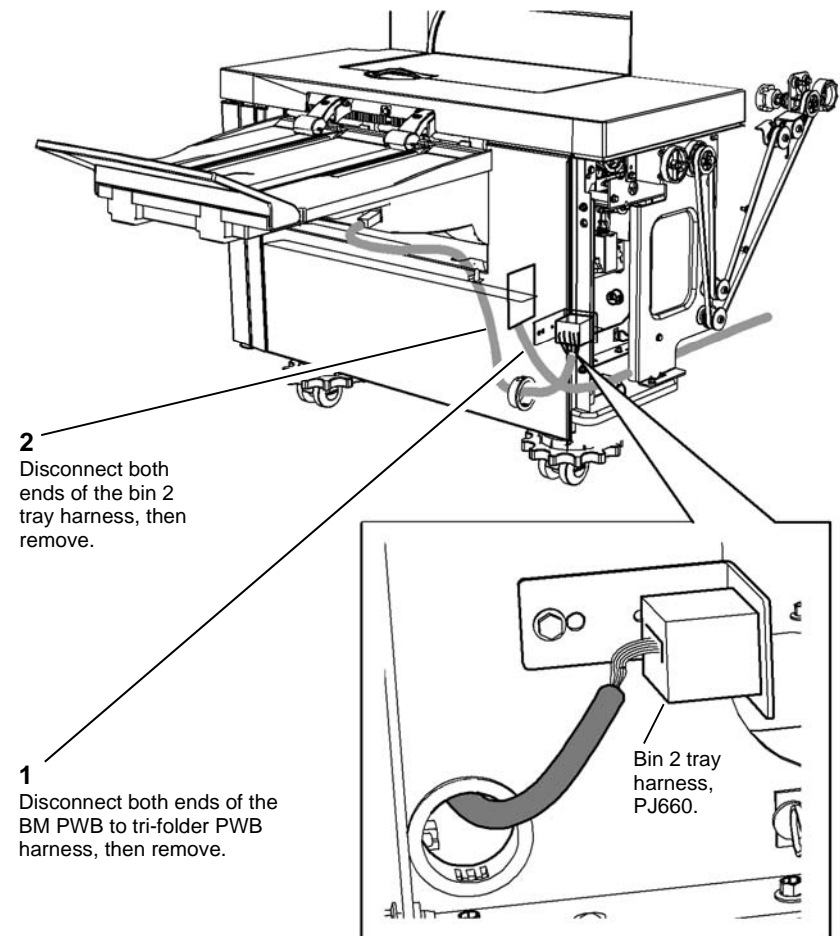
X-1-0569-A

2. Disconnect the PJs then remove the booklet maker PWB to tri-folder PWB harness, [Figure 1](#).
3. Remove the bin 2 tray harness, [Figure 1](#).

Figure 1 Harnesses removal

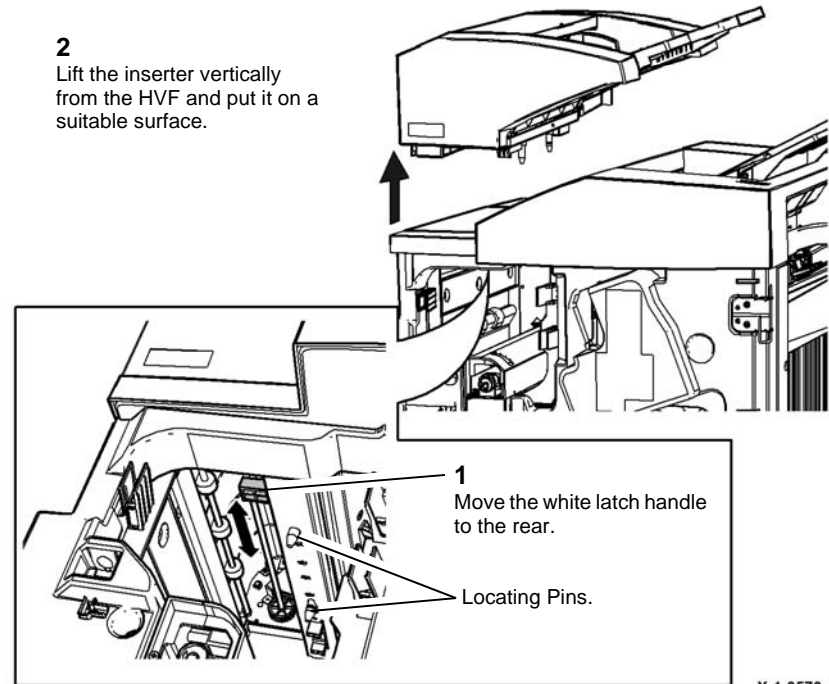
X-1-0570-A

1. Open the HVF front door.
2. Un-dock the inserter, [Figure 1](#).

Figure 1 Inserter un-docking

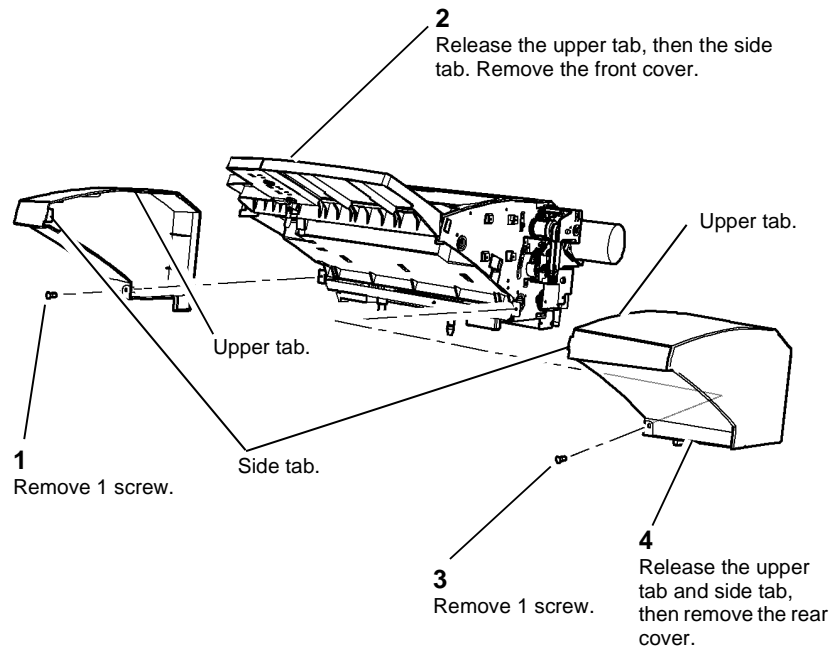
X-1-0571-A

1. Un-dock the Inserter and put it on a suitable surface, [REP 12.82-171](#).
2. Remove the front and rear covers, [Figure 1](#).

Figure 1 Covers removal

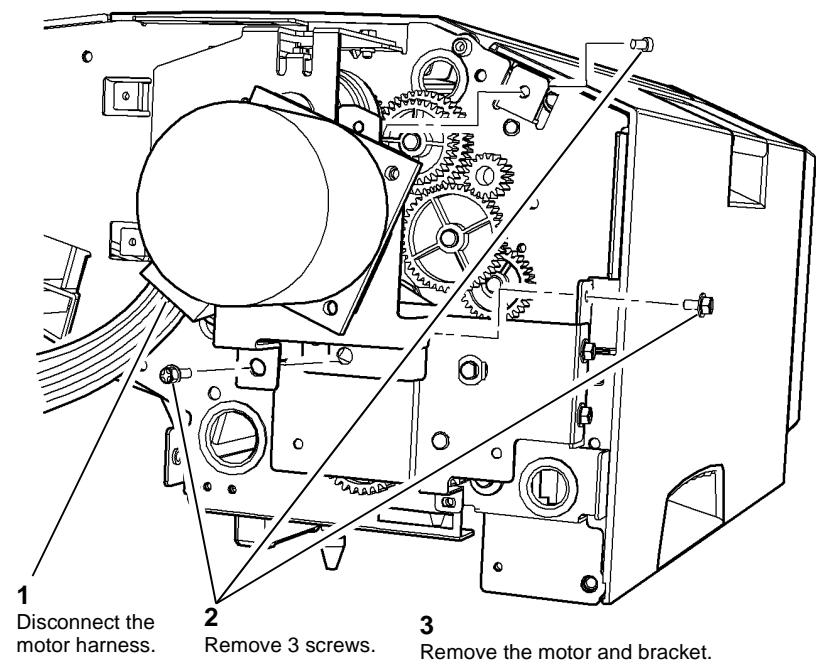
X-1-0572-A

1. Remove the Inserter rear cover, and open the top left door, [REP 12.83-171](#).
2. Remove the inserter motor and bracket, [Figure 1](#).

Figure 1 Motor removal

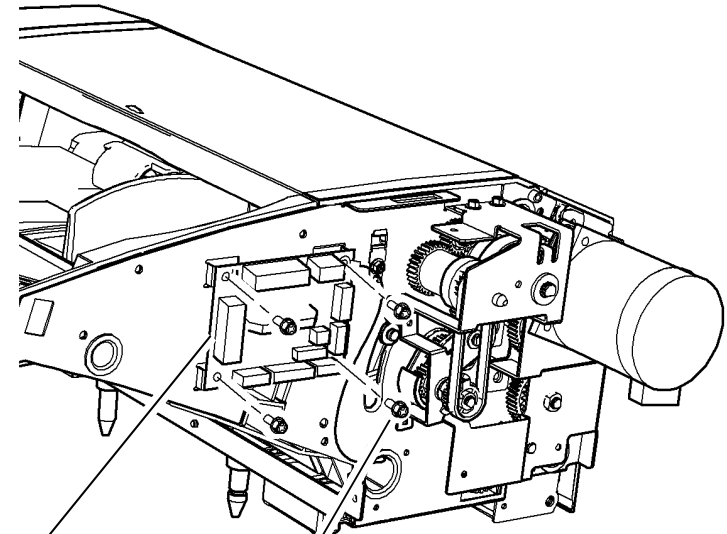
2. Remove the inserter PWB, [Figure 2](#).

3
Remove the
inserter PWB.

2
Remove 4 screws
and the ground wire.

1. Reverse the removal procedures to replace the inserter PWB.
2. Ensure that the ground wire is secured by one of the fixing screws.

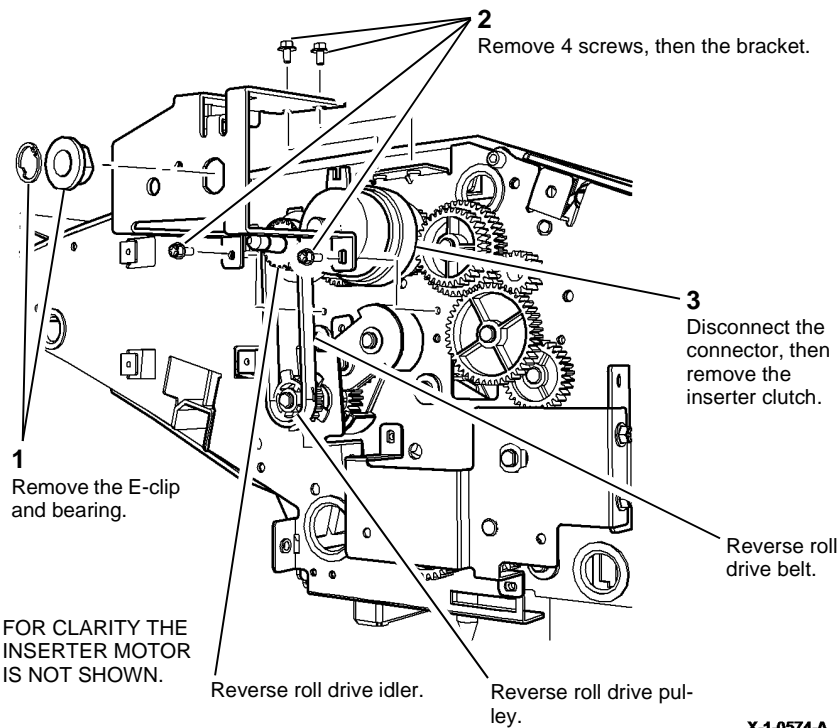
1. Remove the Inserter rear cover. [REP 12.83-171](#).
2. Remove the inserter clutch, [Figure 1](#).

NOTE: The reverse roll drive idler and the drive belt are not attached to the clutch bracket or the Inserter frame.

Figure 1 Inserter clutch removal

1. Reverse the removal procedures to replace the Inserter clutch.
2. When replacing the bracket, check that the clutch torque arm locates in the locating tab.
3. Put the reverse roll drive belt over the drive idler and check that the reverse roll idler gear shaft locates properly into the frame.
4. When the bracket is secured, temporarily remove the E-clip and the reverse roll drive pulley to replace the drive belt over the reverse roll drive pulley.

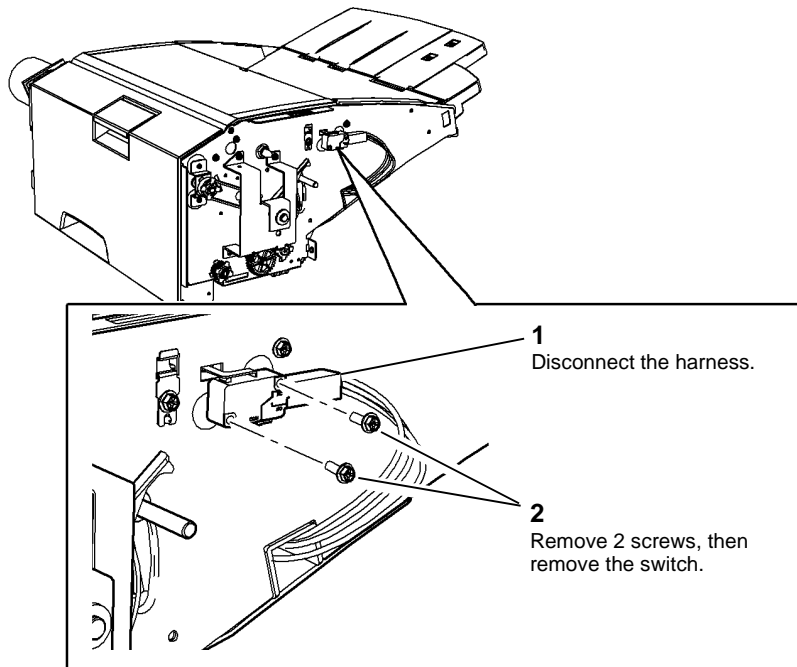
X-1-0575-A

1. Remove the Inserter front cover, [REP 12.83-171](#).
2. Remove the top cover interlock switch, [Figure 1](#).

Figure 1 Switch removal

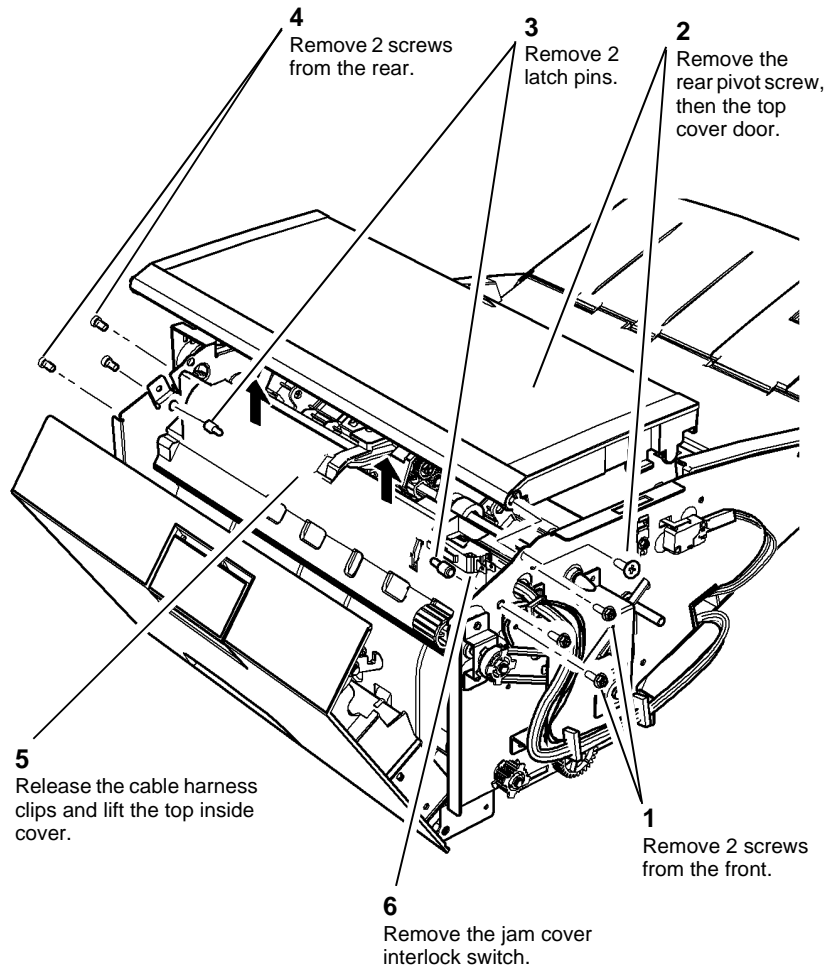
X-1-0576-A

- Remove the top cover door and the interlock switch, [Figure 1](#).

Figure 1 Interlock switch removal
