708P91368
September 2017

Xerox® AltaLink® B8090 Family Multifunction Printer Service Manual

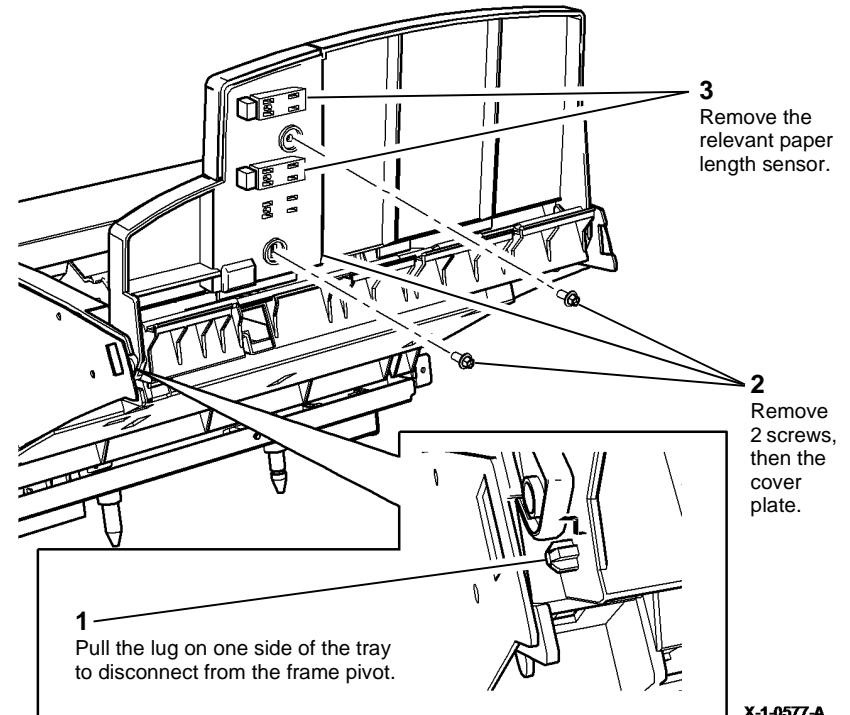
X-1-0577-A

- Remove the relevant sensor, [Figure 1](#)

Figure 1 Sensor removal

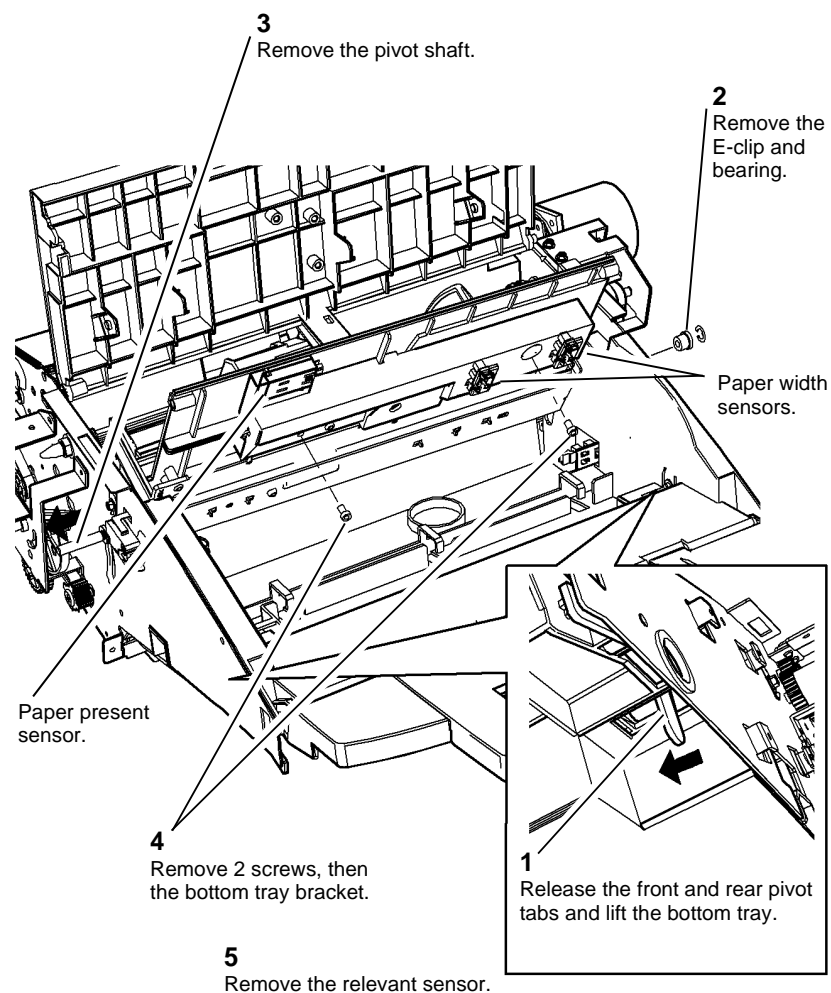
2. Remove the bottom tray bracket, [Figure 1](#).

NOTE: Observe the position of the two springs when lifting the bottom tray.

Figure 1 Tray and sensors removal

1. Reverse the removal procedure to replace the bottom tray and paper sensors.
2. Check that the loading levers are at the same angle and that the tray pivot shaft passes below the front and rear loading levers. Check that the bottom tray is supported horizontally in the frame.
3. Make sure that the bottom tray springs are correctly aligned before engaging the front and rear pivot tabs.

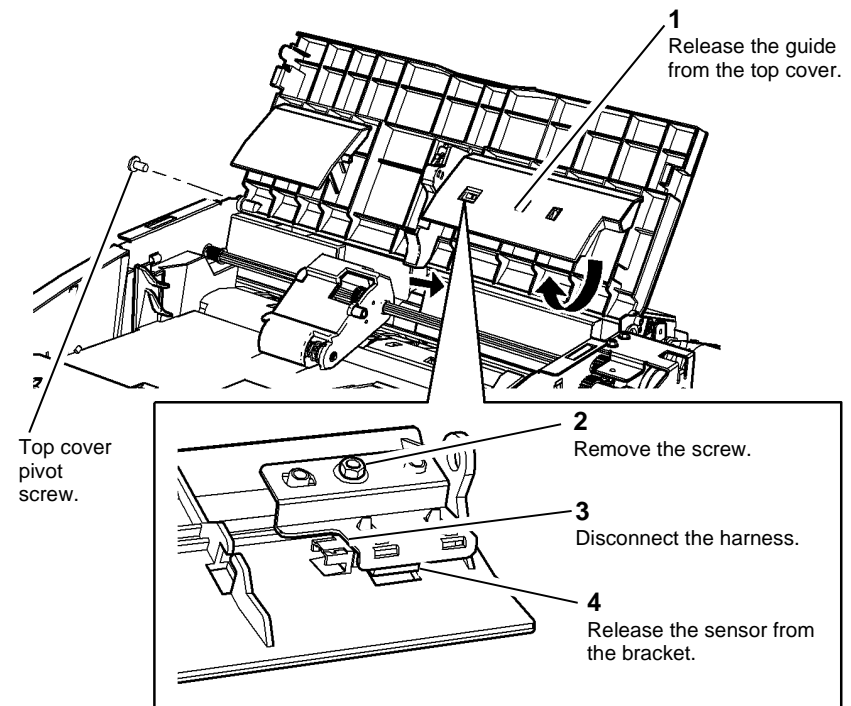
X-1-0579-A

1. Remove the Inserter front cover, [REP 12.83-171](#).
2. To release the top cover, remove the pivot screw, [Figure 1](#).
3. Remove the inserter pickup sensor, [Figure 1](#).

Figure 1 Pickup sensor removal

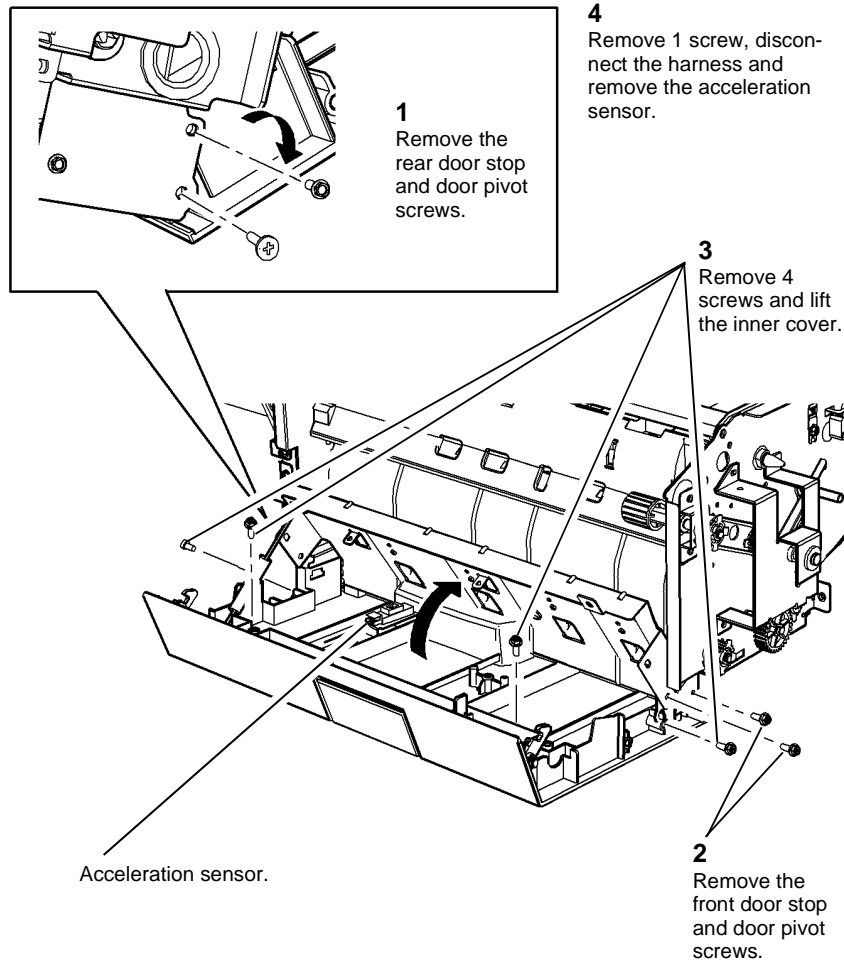
X-1-0580-A

2. Remove the acceleration sensor. [Figure 1](#).

Figure 1 Cover and sensor removal

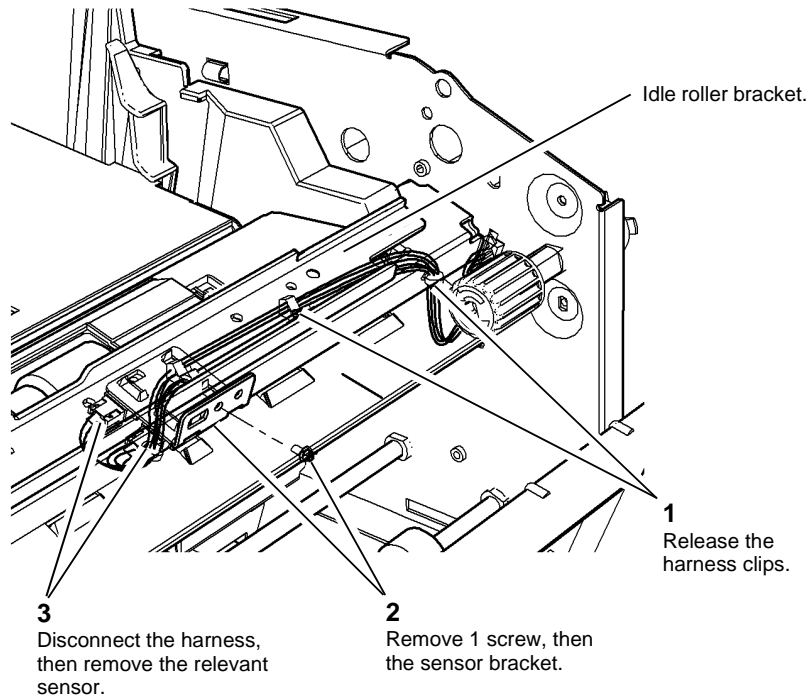
X-1-0581-A

- Remove the LE sensor or TE sensor, [Figure 1](#).

Figure 1 Sensors removal

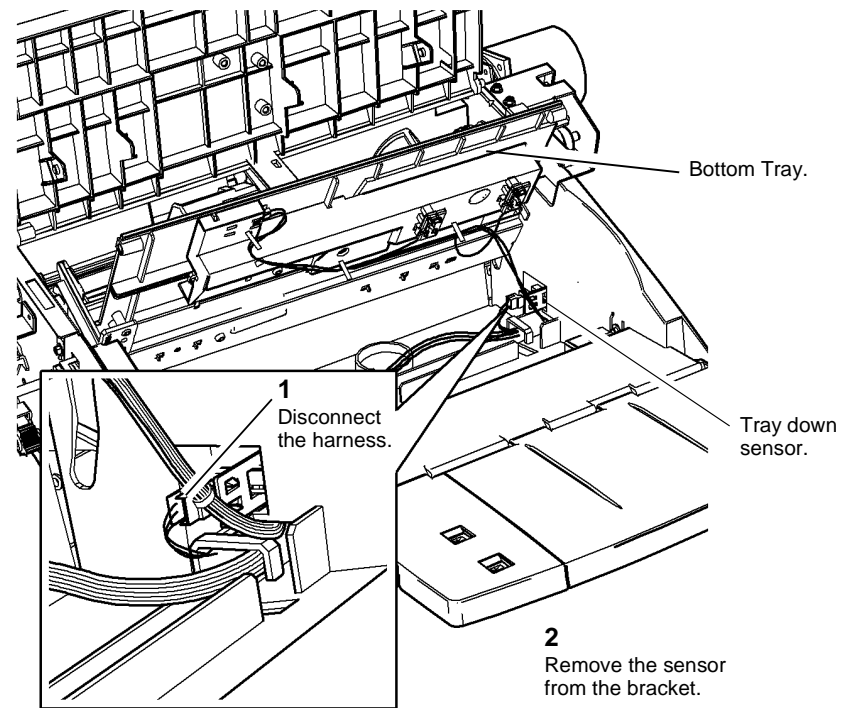
X-1-0582-A

- Un-dock the Inserter, [REP 12.82-171](#), and release the front and rear pivot tabs then lift the bottom tray. Control the movement of the bottom tray springs.
- Remove the sensor from the bracket, [Figure 1](#).

Figure 1 Sensor removal

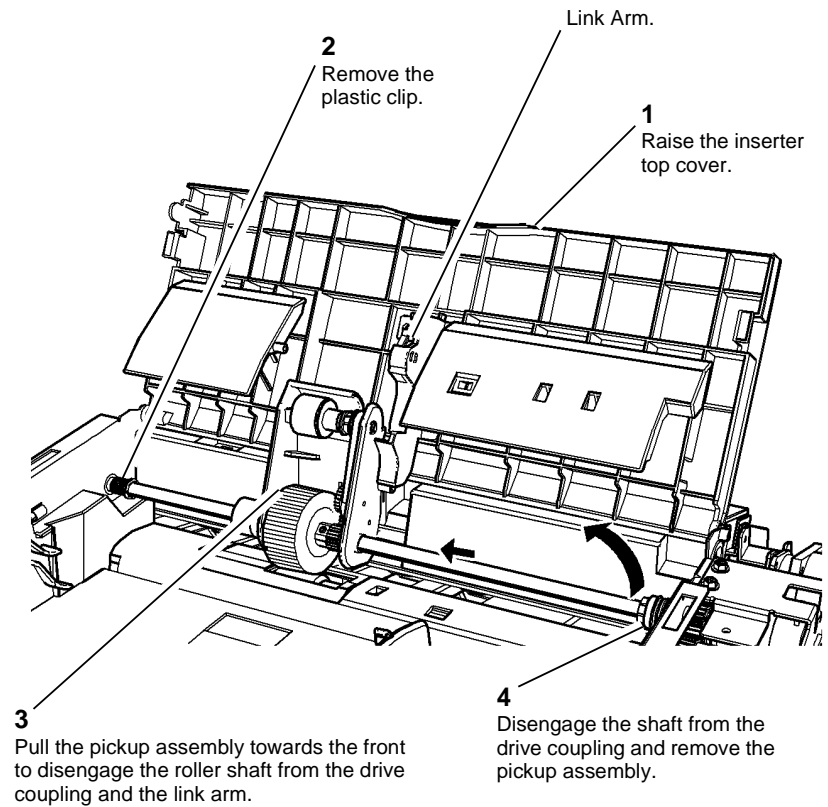
X-1-0583-A

1. Remove the pickup assembly from the inserter, [Figure 1](#).

Figure 1 Pickup assembly removal

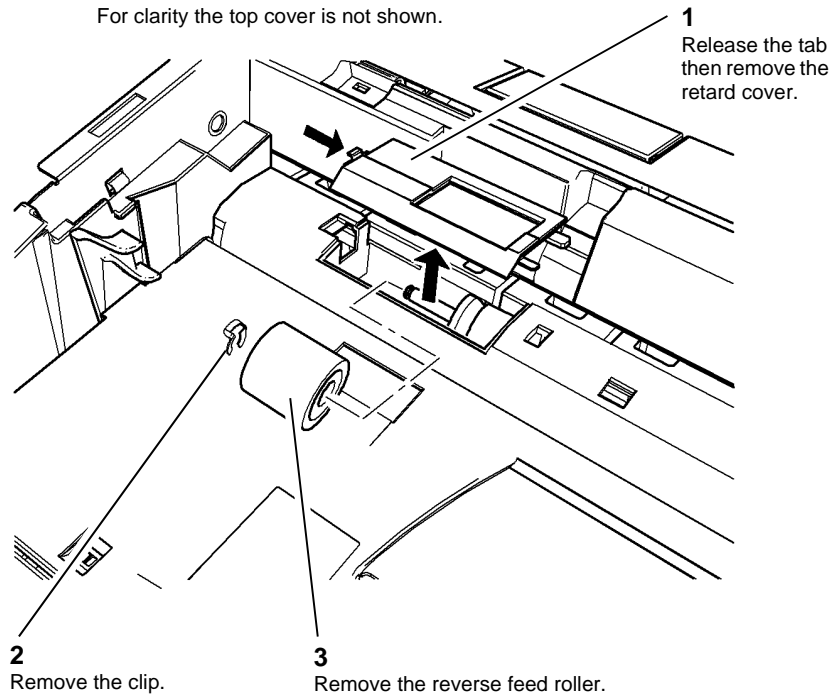
X-1-0584-A

2. Remove the reverse roller and coupling from the reverse roller shaft, [Figure 2](#).

Figure 2 Reverse roller removal

1. Reverse the removal procedure to replace the reverse and the pickup roller assemblies.
2. After replacing the pickup roller assembly close the Inserter top cover fully to engage the link arm with the pickup roller.
3. If a new inserter pickup assembly is installed, reset the inserter feed count to zero. Refer to [dC135 CRU / HFSI Status](#).

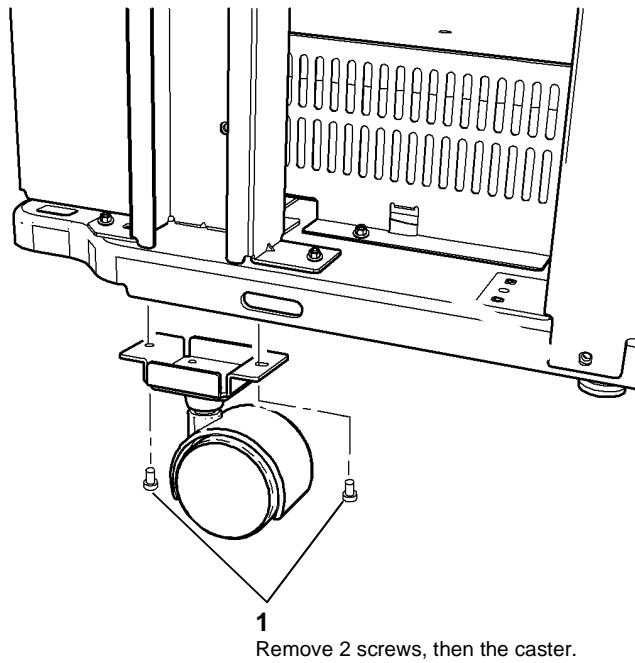
X-1-0585-A

4. Remove the fixed caster, [Figure 1](#).

Figure 1 Fixed caster removal

1. Un-dock the tri-folder from the HVF, [REP 12.82-171](#).
2. Un-dock the HVF from the copier and remove the HVF front and rear covers, [REP 12.1-171](#).
3. Get help to lift and support the HVF frame securely at a position close to where the caster is to be removed, [GP 16](#). Support the frame approximately 4 inches (approximately 2 reams of paper) above the floor so that the caster is not supporting the unit.

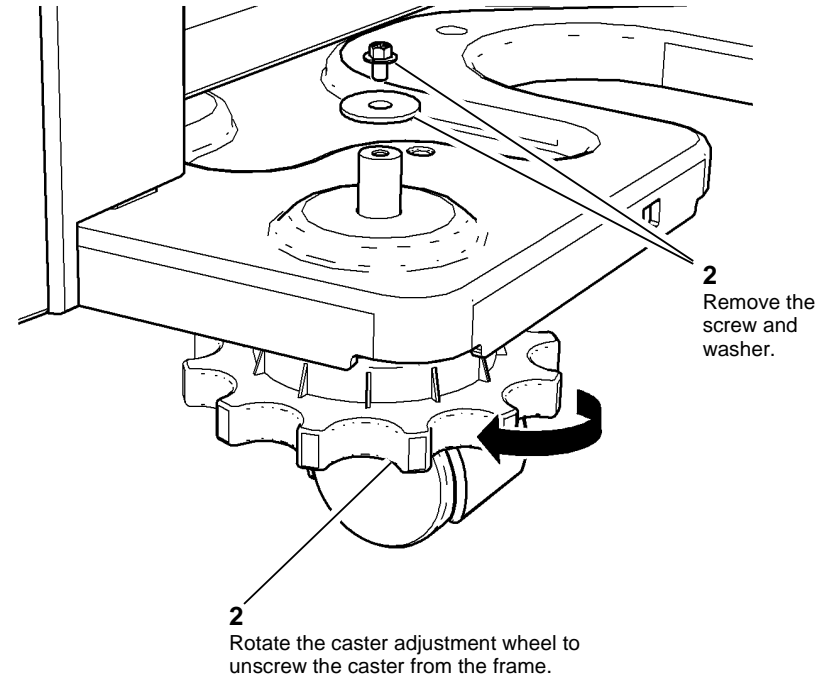
X-1-0586-A

5. Support the HVF frame. Remove the adjustable caster, [Figure 2](#).

Figure 2 Adjustable caster removal

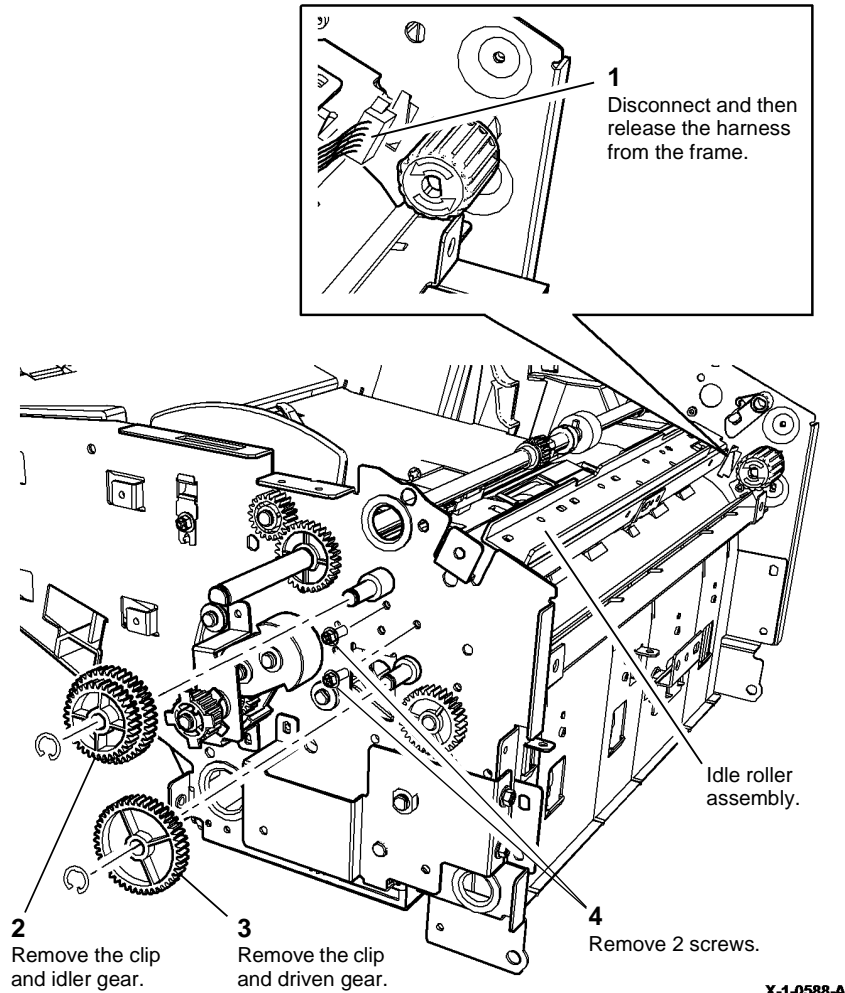
6. Prepare to remove the idle roller assembly, [Figure 1](#).

Figure 1 Preparation

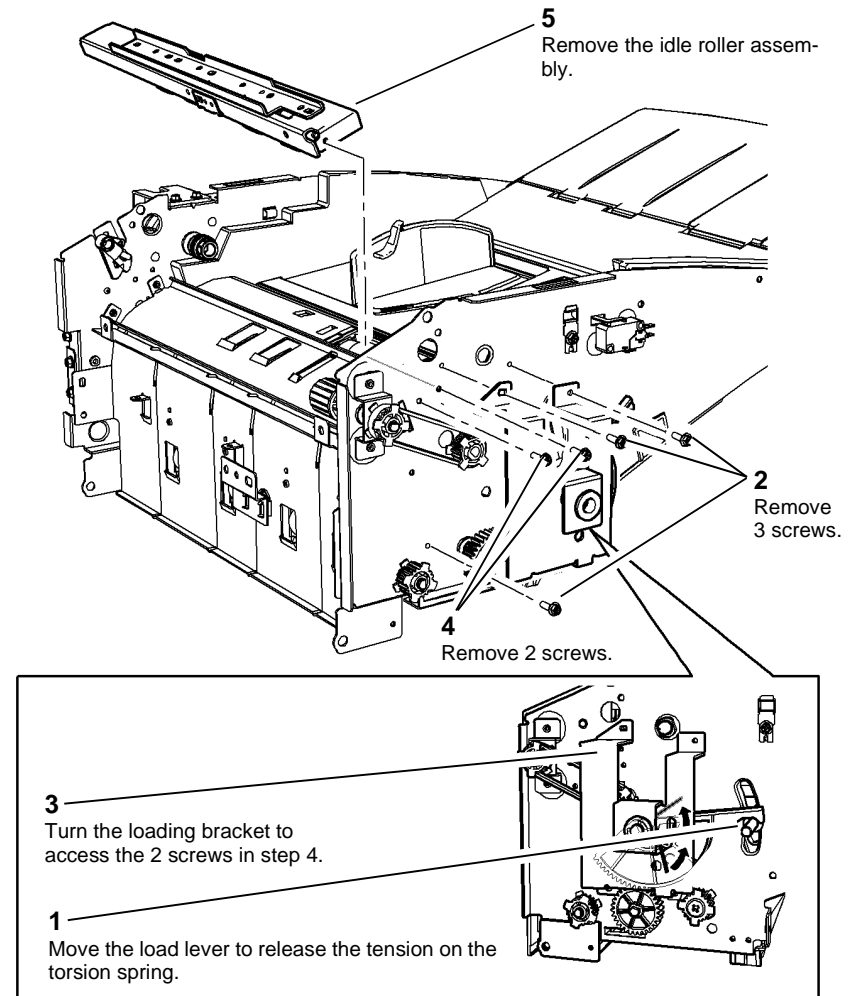
7. Remove the idle roller assembly, [Figure 2](#).

NOTE: Check that the loading gear remains engaged with the loading shaft gear.

Figure 2 Idle roller assembly removal

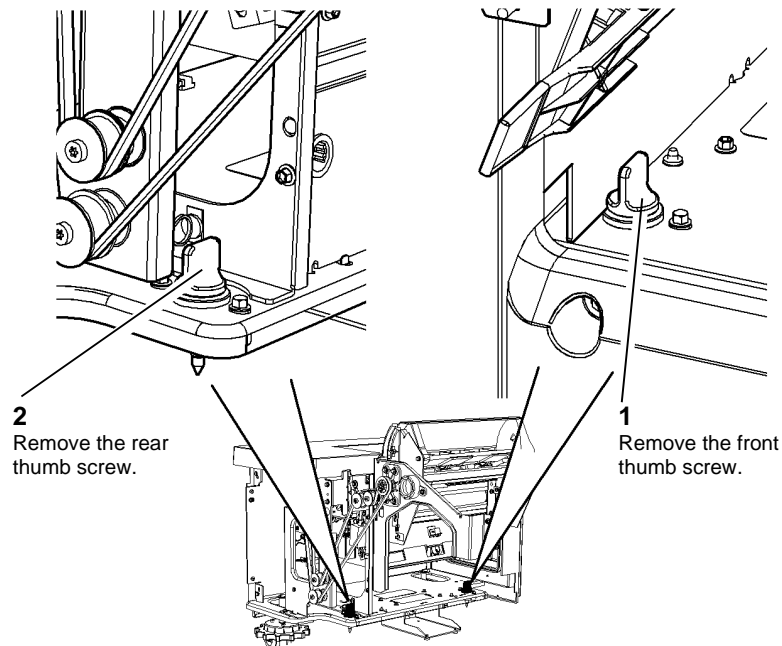
X-1-0590-A

Figure 1 Thumb screw removal

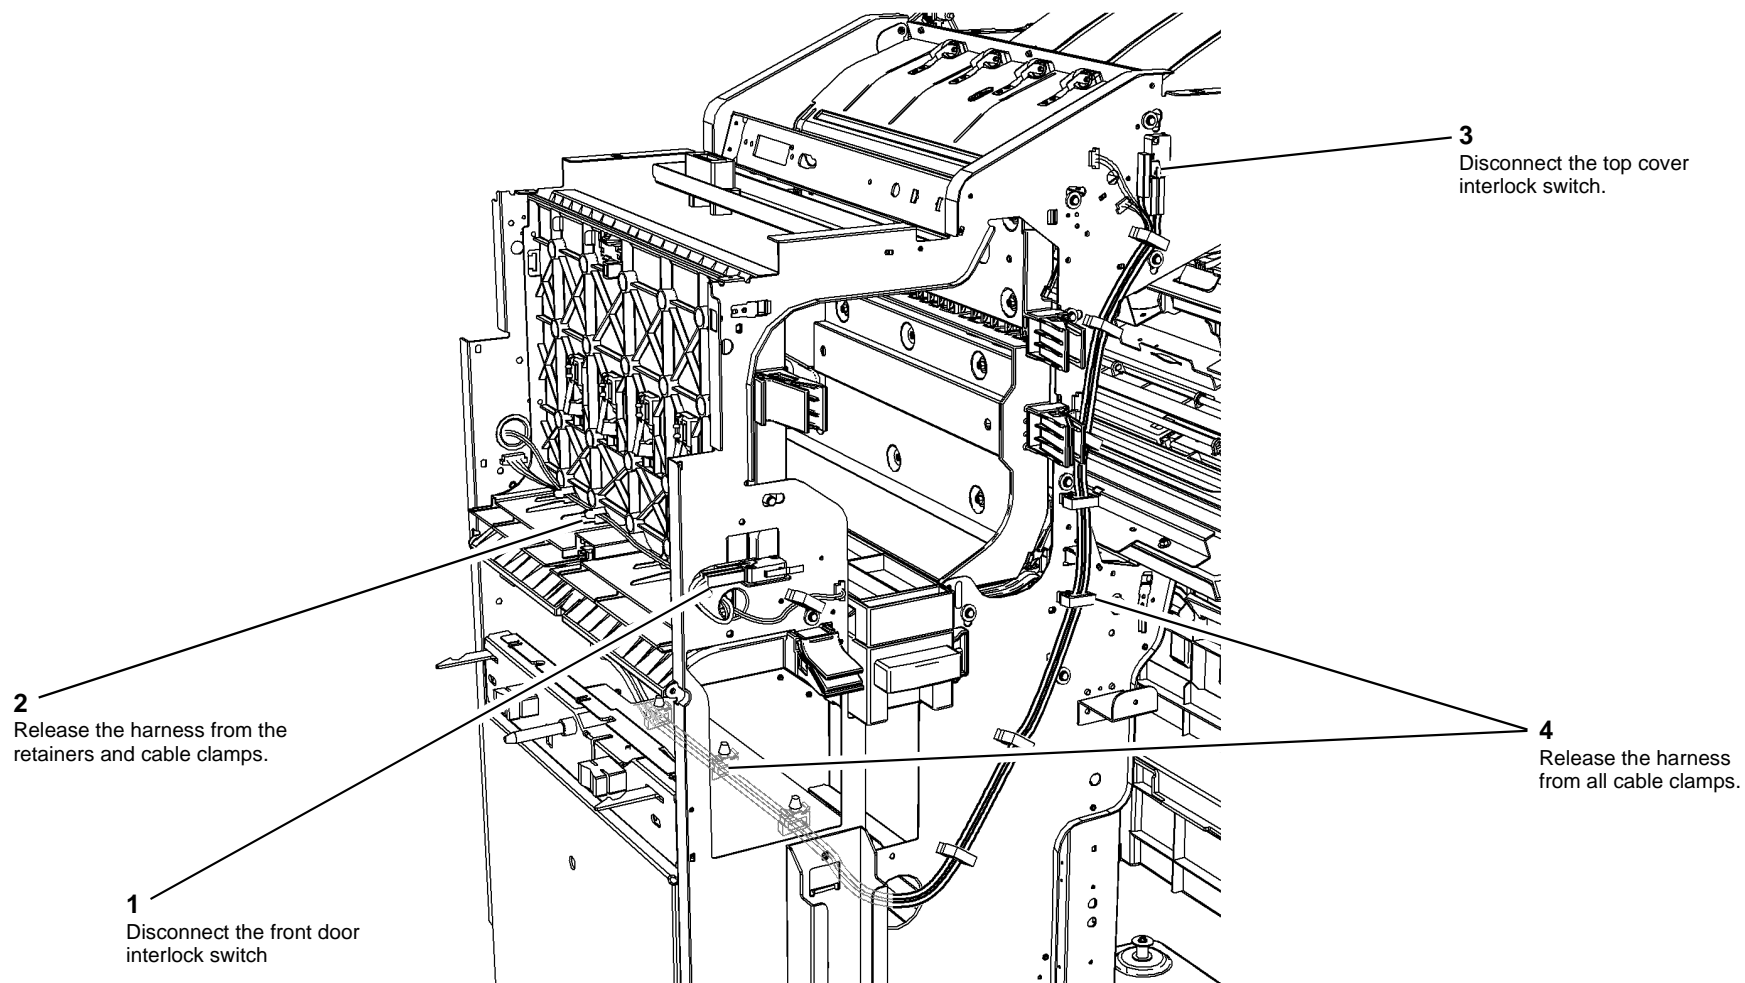
X-1-2030-A

1. Un-dock the HVF or HVF BM, **REP 12.13-171**.
2. Refer to **REP 12.1-171**. Remove the following covers:
 - Top cover, **PL 12.100 Item 1**.
 - Rear cover, **PL 12.100 Item 5**.
 - Front cover, **PL 12.100 Item 2**.
 - Vent cover, **PL 12.100 Item 6**.
3. Disconnect the front interlock switches, **Figure 1**.

Figure 1 Front interlock switches

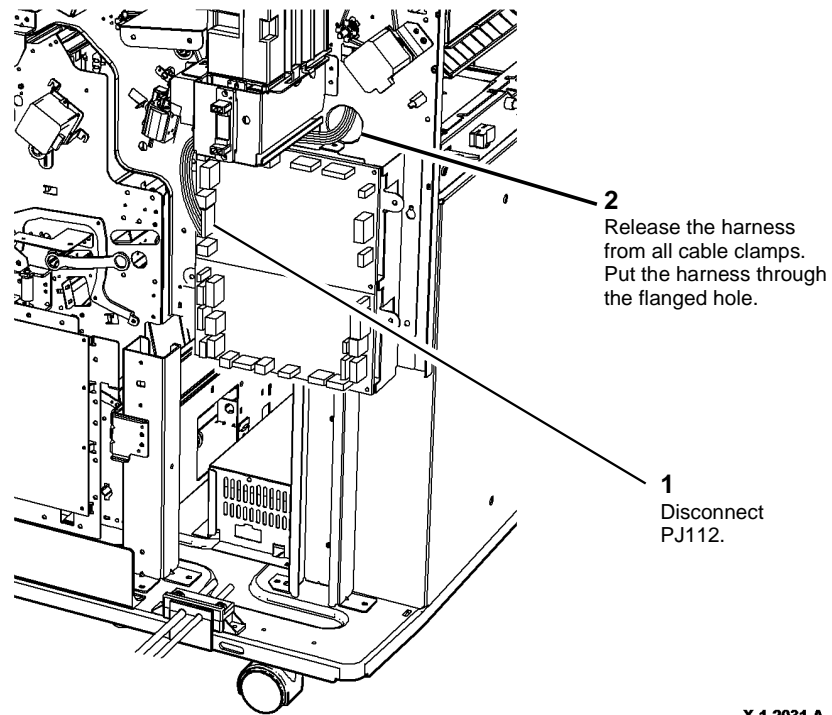
X-1-2031-A

4. Prepare to remove the docking latch assembly, [Figure 2](#).

Figure 2 Preparation

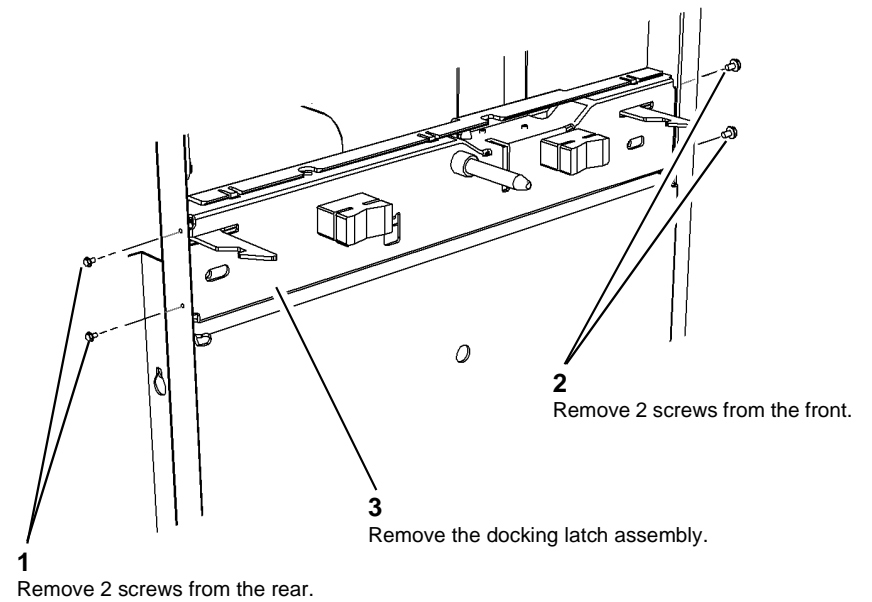
X-1-2032-A

5. Remove the docking latch assembly, [Figure 3](#).

Figure 3 Removal

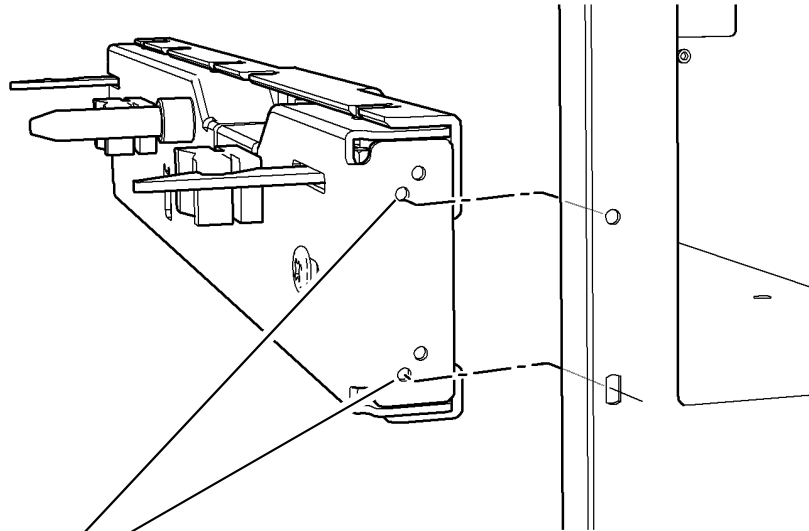
X-1-2033-A

1. The replacement is the reverse of the removal procedure.
2. Ensure the 2 screws at the front locate in the correct holes, [Figure 4](#).

1
Secure the front of the latch assembly using the screw holes shown.

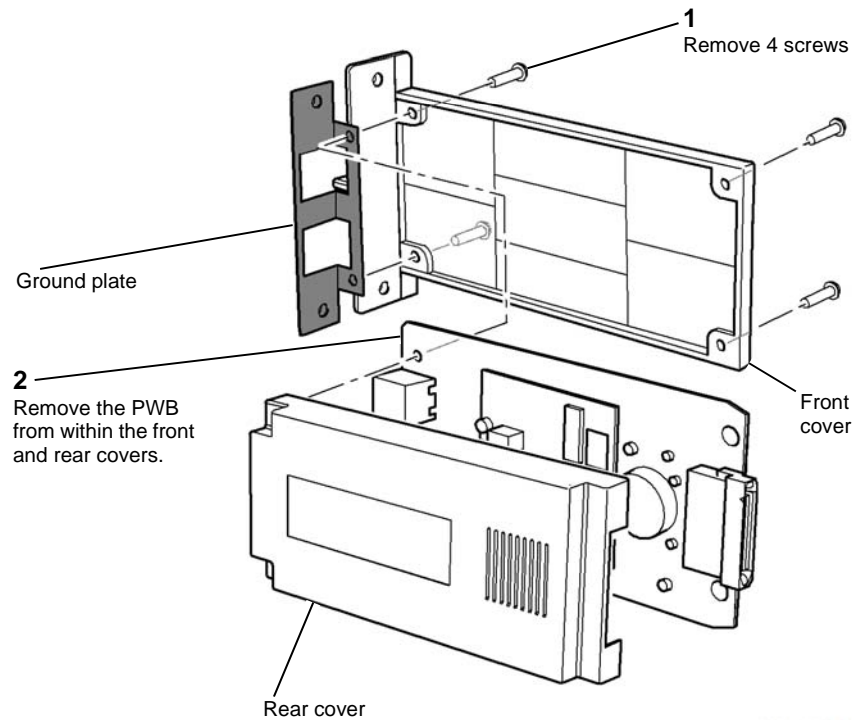
X-1-1290-A

1. Switch off the machine, [GP 14](#).
2. Disconnect the telephone cable(s), [PL 20.05 Item 3](#).
3. Remove the fax module (2 thumb screws).
4. [Figure 1](#), remove the fax PWB.

Figure 1 Fax PWB removal

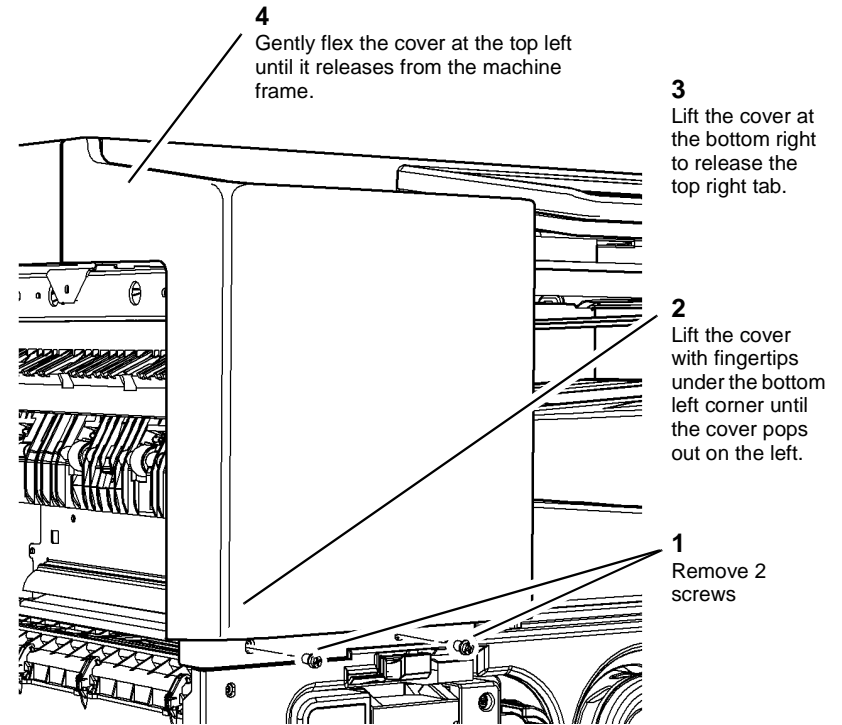
4. Remove the left frame cover, [PL 2.10 Item 9](#), [Figure 1](#).

Figure 1 Left frame cover removal

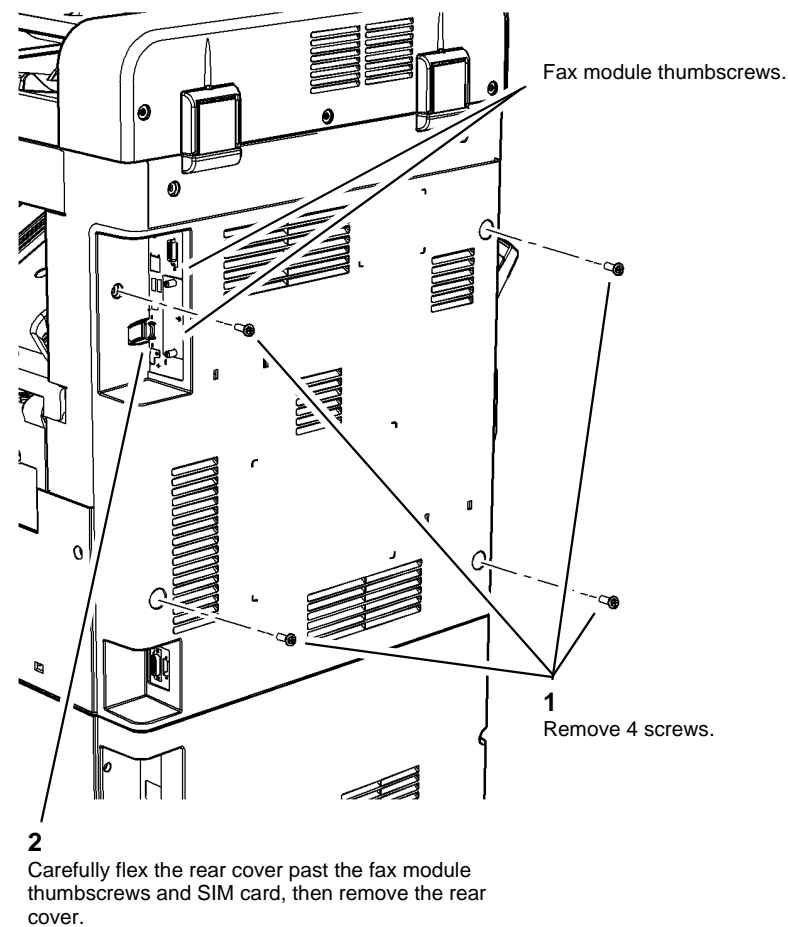
X-1-1316-A

2. Remove 4 screws from the rear cover, [Figure 1](#).

Figure 1 Removal

Take care not to pull the wire. The wire to the rear fan duct can break easily. Refer to [Figure 2](#) before removing the screws.

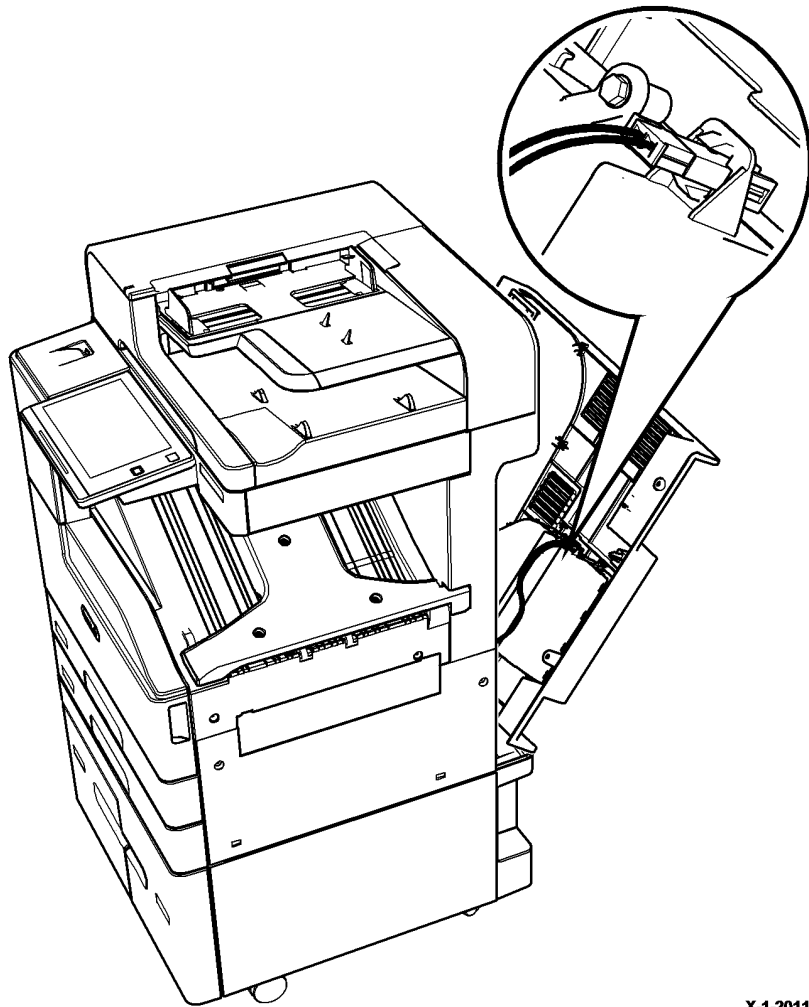
X-1-2011-A

Take care not to pull the wire tight. The wire to the fan is easily broken.

3. Pull the cover away, [Figure 2](#).

Figure 2 Removal

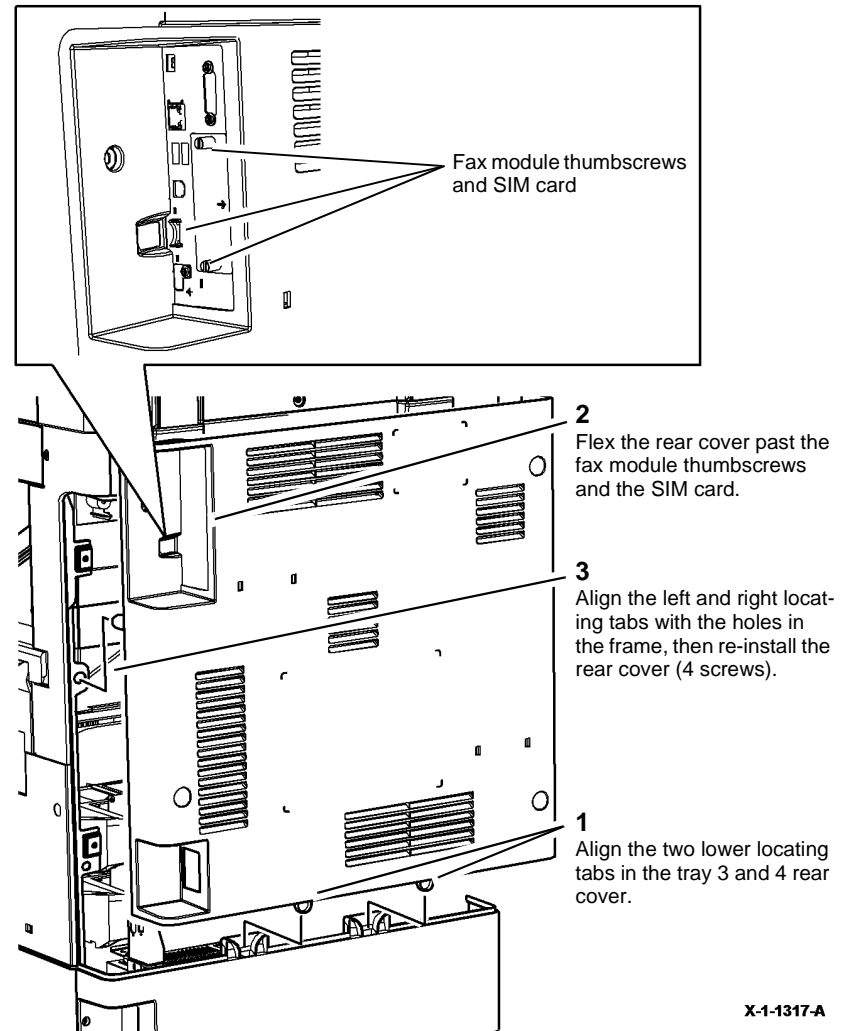
X-1-1317-A

1. Re-install the rear cover, [Figure 3](#).

Figure 3 Replacement

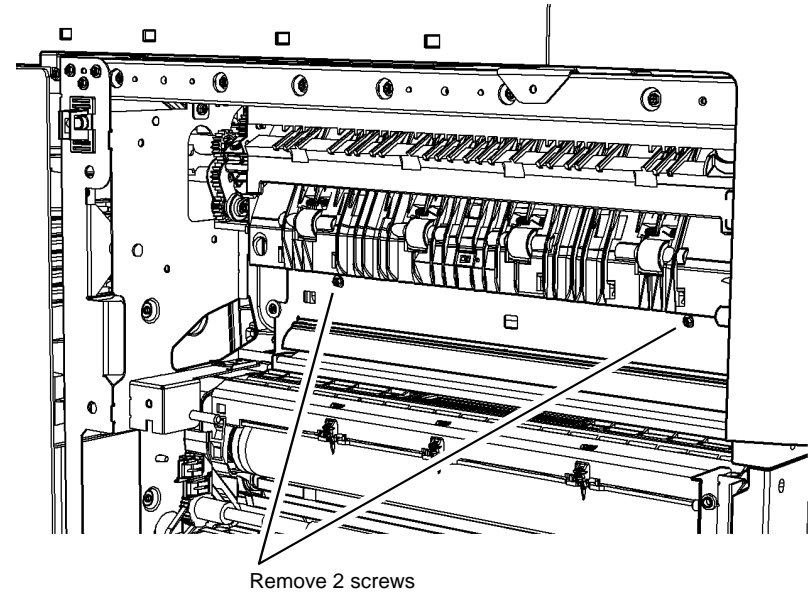
X-1-2013-A

1. Remove the horizontal transport assembly, [REP 10.6](#) or the centre output tray, [REP 10.9](#).
2. Remove the fuser.
3. Remove 2 screws behind the fuser, [Figure 1](#).

Figure 1 Remove 2 screws

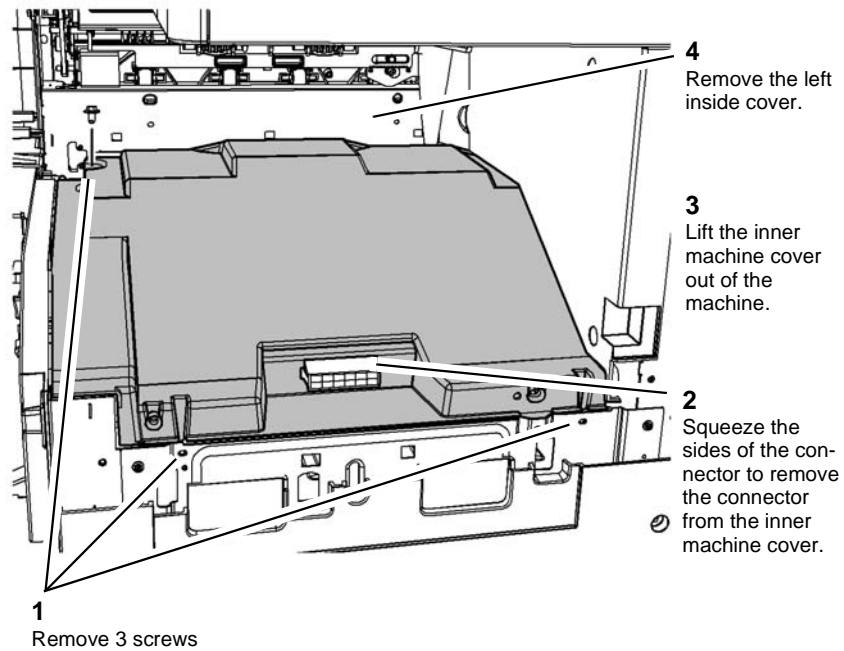
7. Remove the inner machine cover and the left inside cover, PL 28.10 Item 14, Figure 2.

Figure 2 Inner machine cover removal

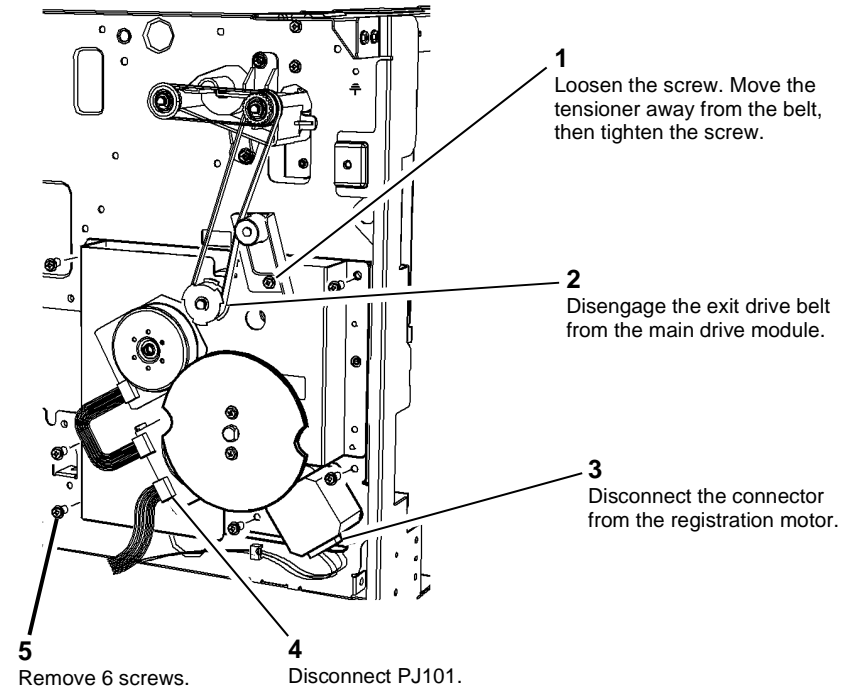
1. Remove the fuser, [PL 10.8 Item 1](#).
2. Remove the print cartridge, [PL 90.17 Item 9](#), then place in a black bag.
3. Remove the rear cover, [REP 28.2](#).
4. Prepare to remove the main drive module, [Figure 1](#).

Figure 1 Preparation

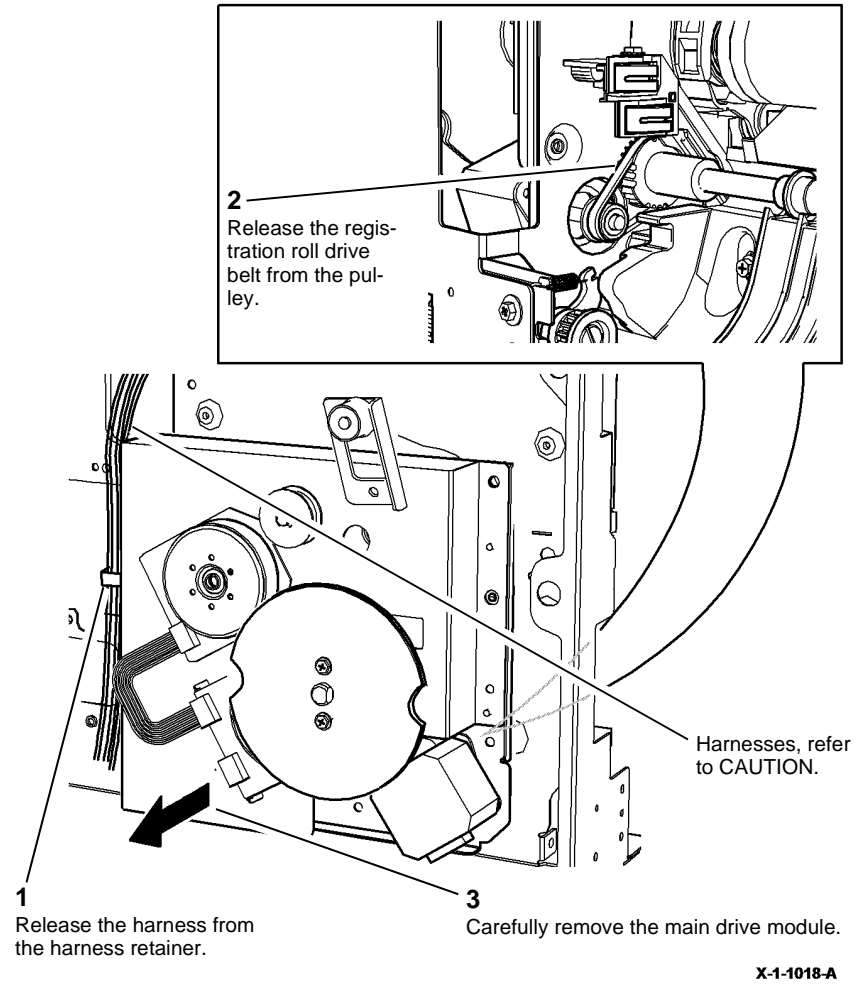
5. Remove the main drive module. Refer to **Figure 2**.

Figure 2 Removal

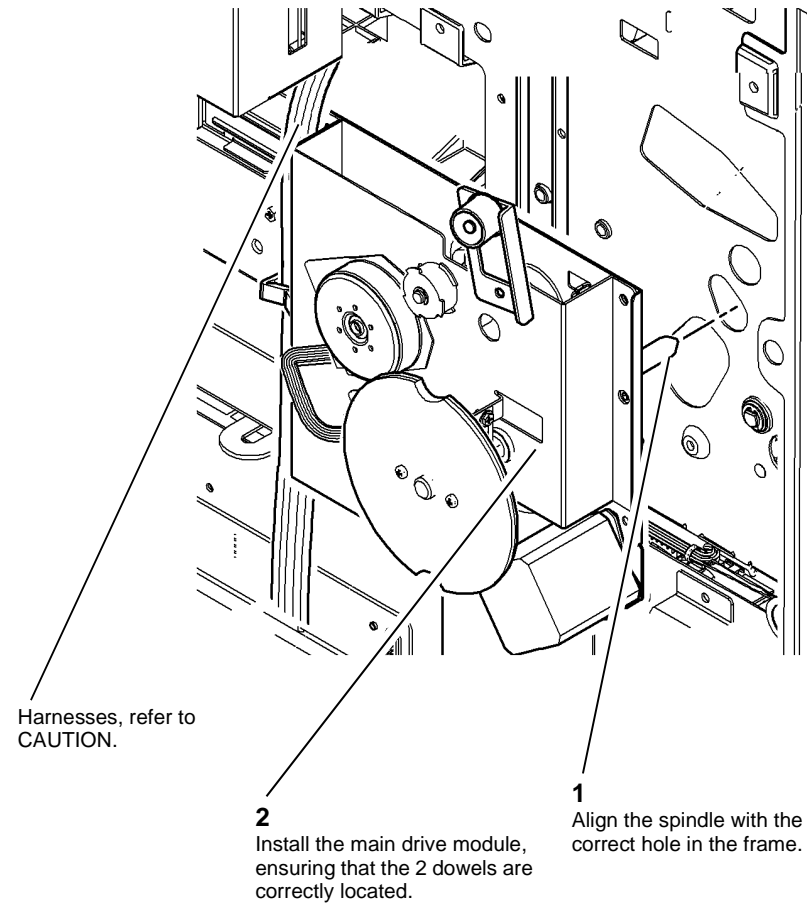
1. Check that the gears are adequately greased, if necessary perform the Main Drive Module procedure of **ADJ 40.1**.
2. Install the main drive module, **Figure 3**.

Figure 3 Replacement

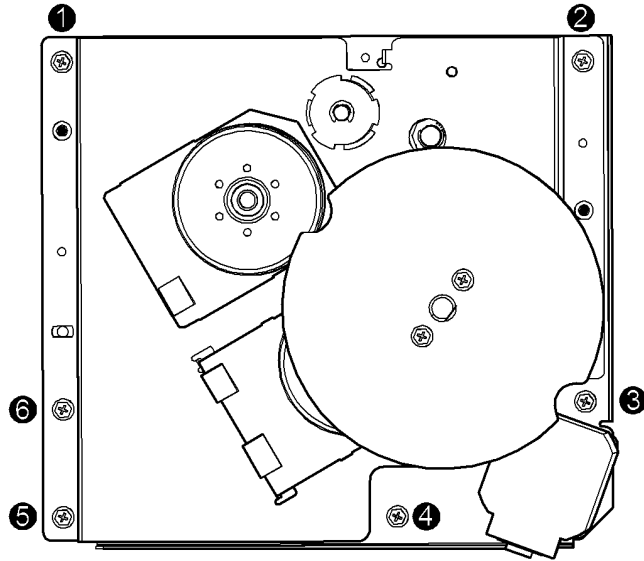
3. Figure 4, secure the drives module to the machine frame.

1
Loosely insert 6 screws.

2
Tighten the 6 securing screws in the order shown. See Caution.

To ensure optimum image quality, ensure that the securing screws are tightened in the order given in Figure 4.

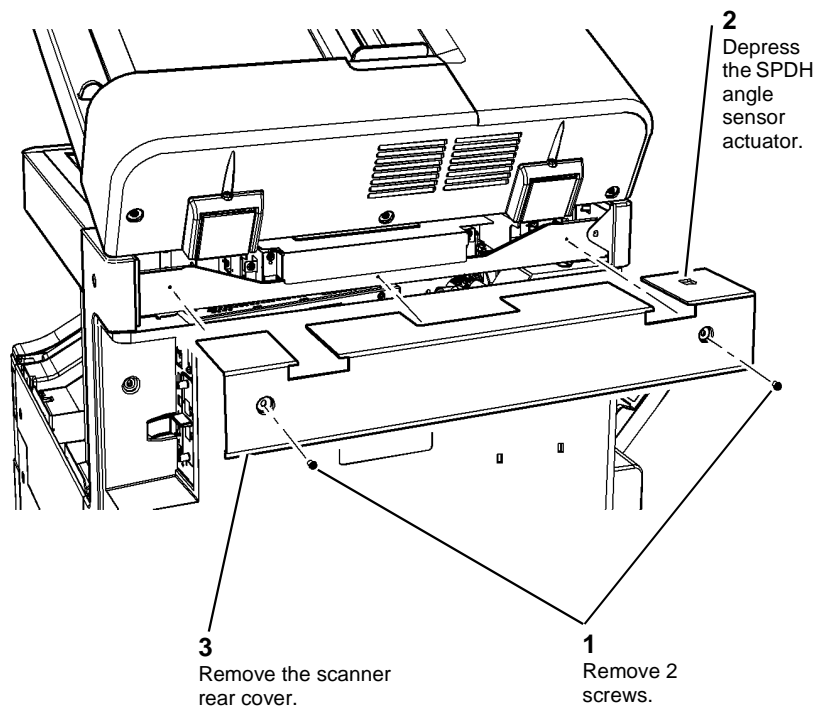
1. Raise the SPDH, [PL 5.10 Item 9](#).
2. Remove the scanner rear cover, [Figure 1](#).

Figure 1 Scanner rear cover

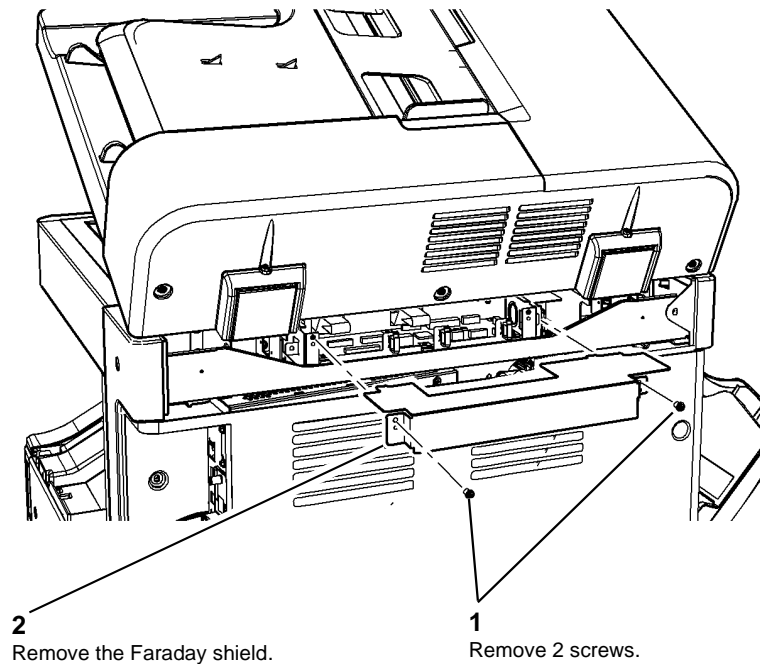
3. Remove the Faraday shield, [Figure 2](#).

Figure 2 Faraday shield removal

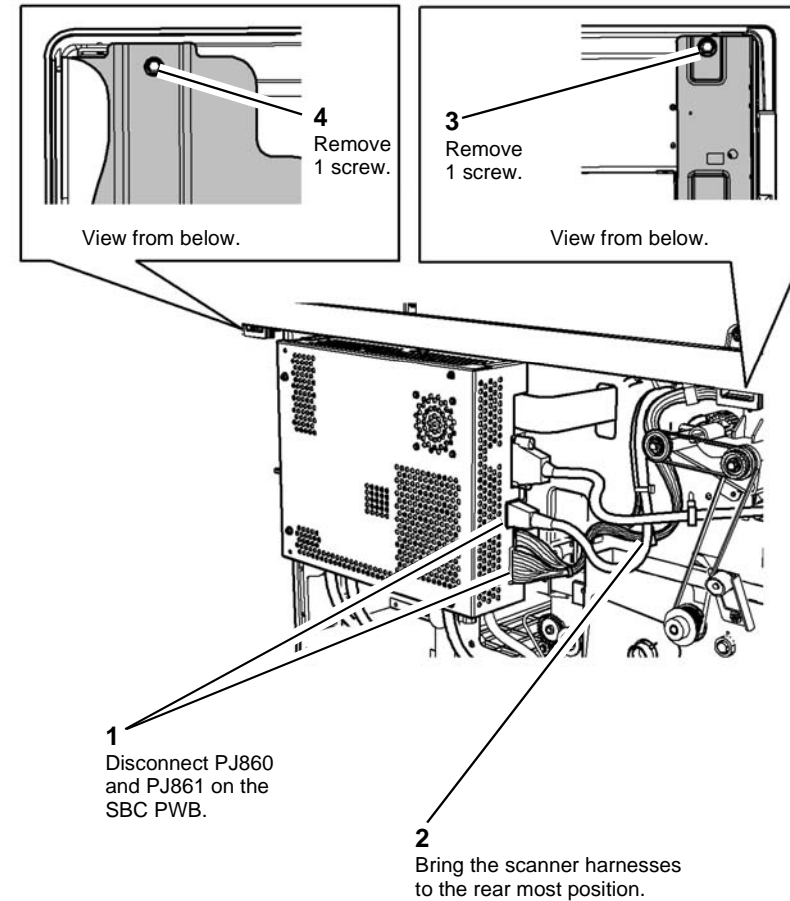
Figure 1 Scanner removal preparation

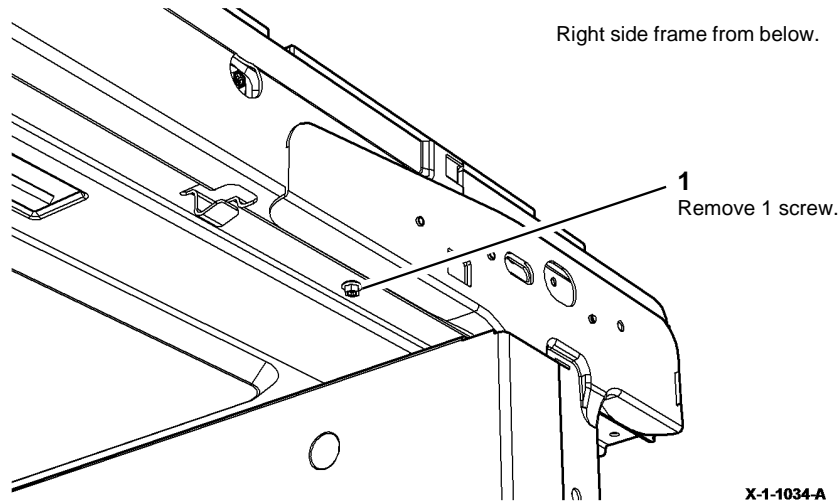
12. Remove the scanner module fixing screw, [Figure 2](#).

Figure 2 Scanner fixing removal
