708P91368
September 2017

Xerox® AltaLink® B8090 Family Multifunction Printer Service Manual

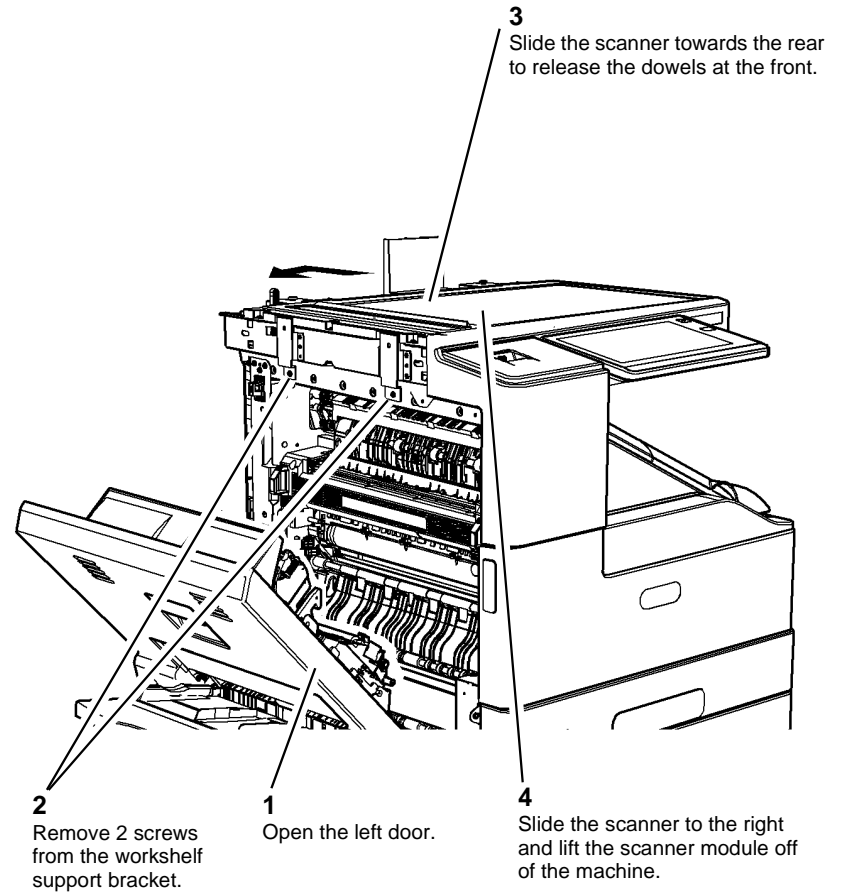
13. Remove the scanner, [Figure 3](#).

Figure 3 Scanner removal

1. If a new scanner module is being installed remove the workshelf support bracket, [Figure 3](#) from the old scanner module, then attach it to the new scanner module.
2. The replacement procedure is the reverse of the removal procedure.
3. Perform [ADJ 60.3](#) IIT Registration, Magnification and Calibration.
4. Ensure that the machine serial number in [dC132](#) is correct. If necessary, enter the correct serial number.

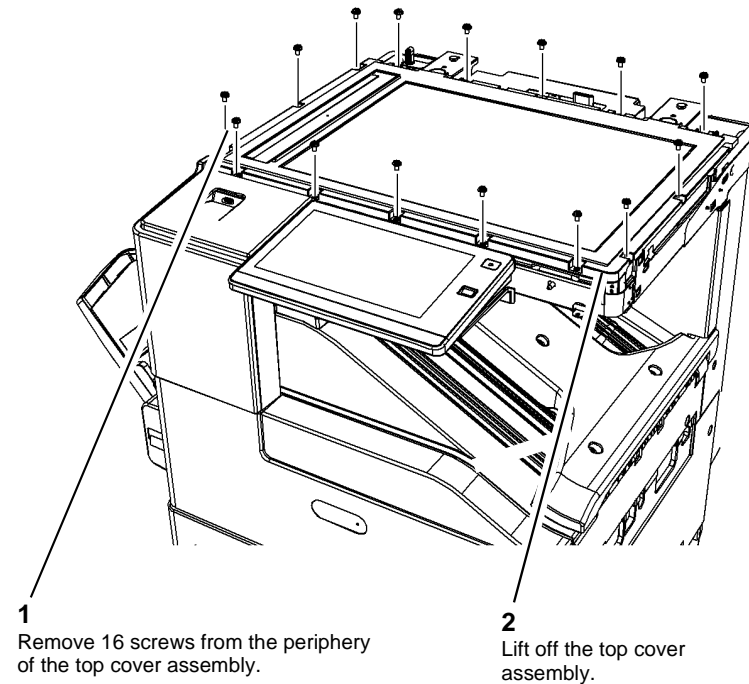
8. Remove the top cover assembly, [Figure 1](#).

Figure 1 Top cover assembly

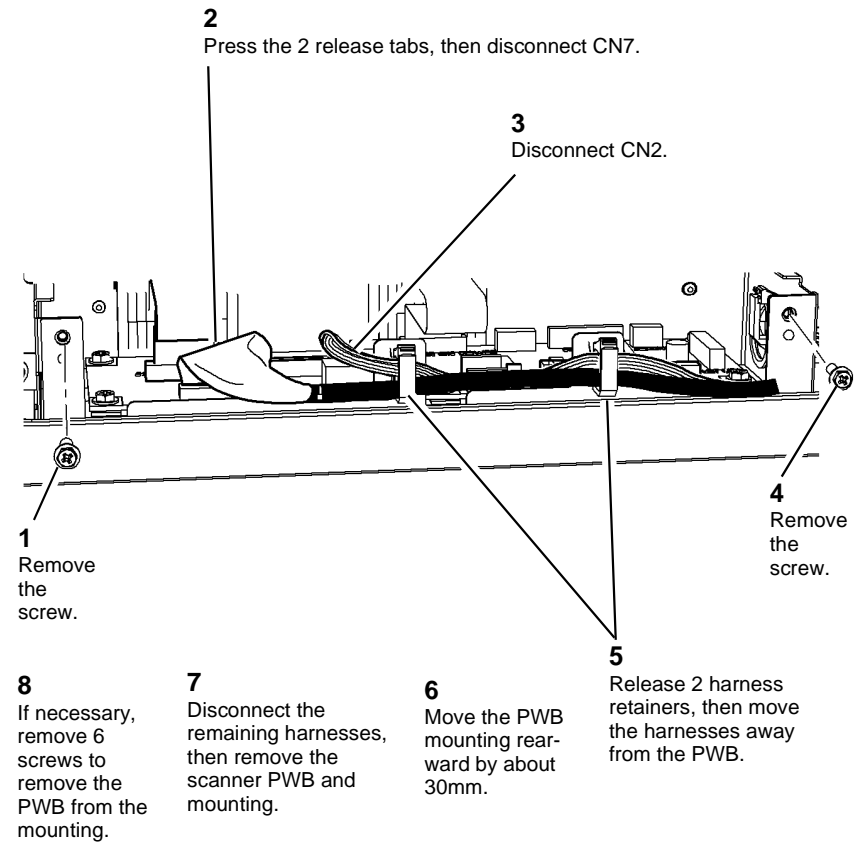
2. Remove the scanner PWB, [Figure 1](#).

Figure 1 Scanner PWB

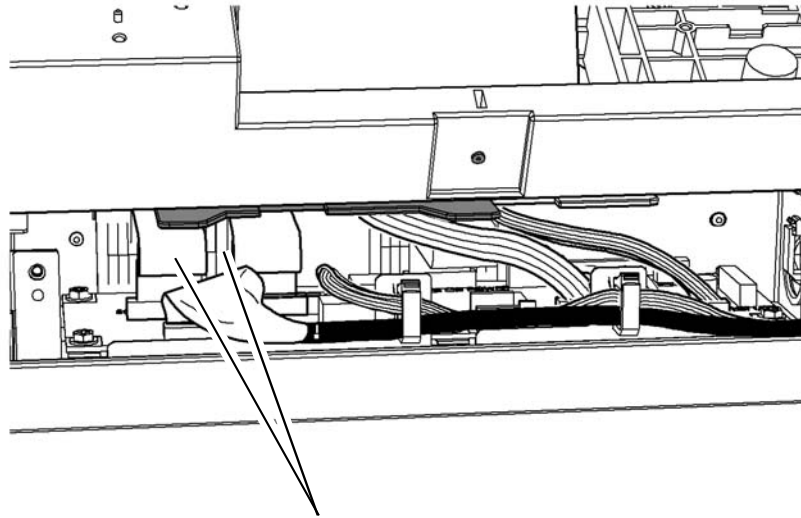
2. Before installing the scanner rear cover, dress the position of the ribbon cables, [Figure 2](#).

1. Ensure that all slack in both ribbon cables is pulled from the optics cavity and folded over the scanner PWB.

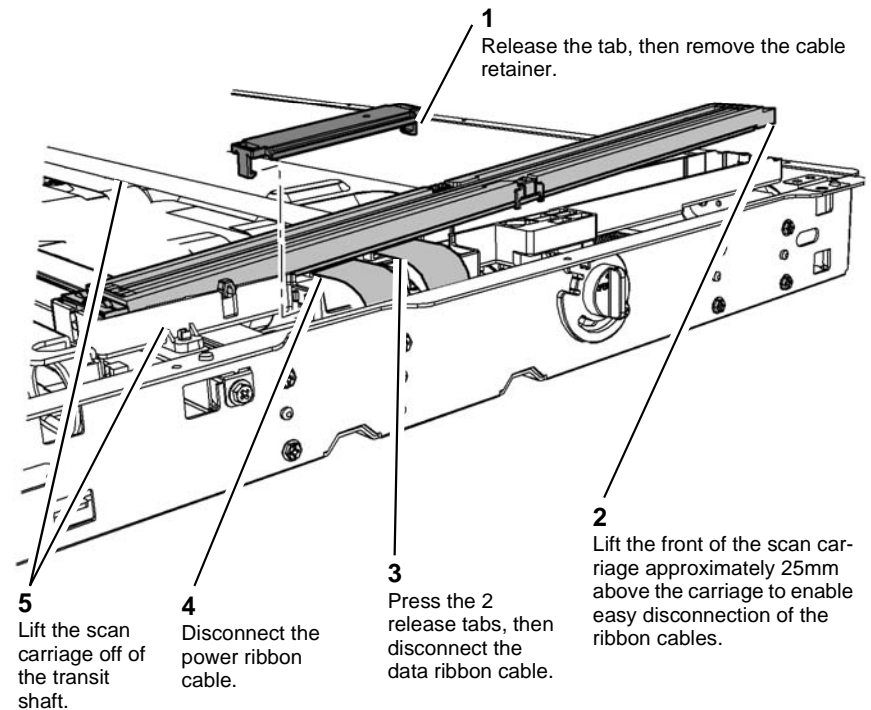
1. Remove the top cover assembly, [REP 60.3](#).
2. Remove the scan carriage drive belt, [REP 60.10](#).
3. Remove the scan carriage, [Figure 1](#).

Figure 1 Scan carriage removal

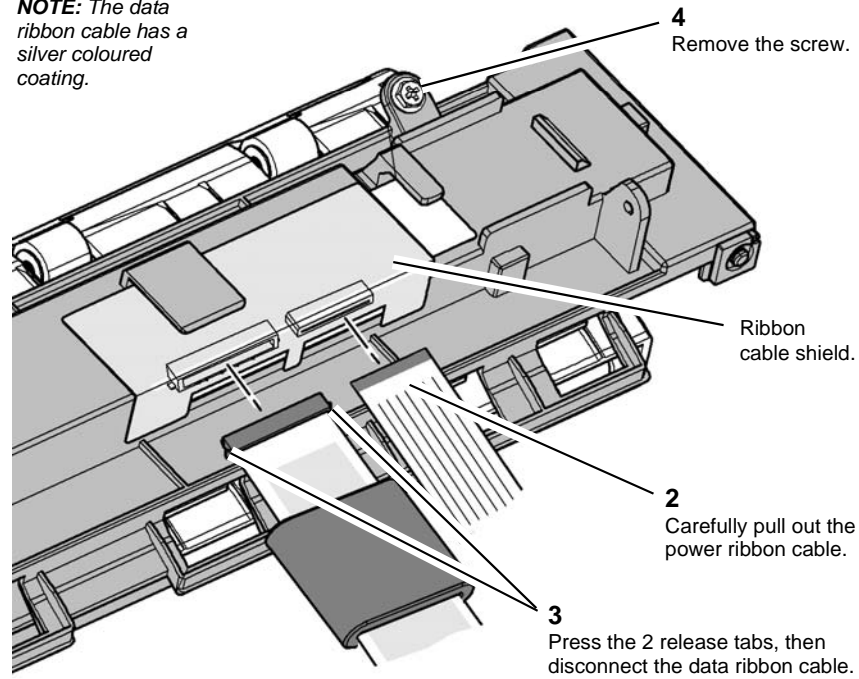
7. Disconnect the harnesses and rear fixing, [Figure 1](#).

NOTE: The data ribbon cable has a silver coloured coating.

Figure 1 Preparation 1

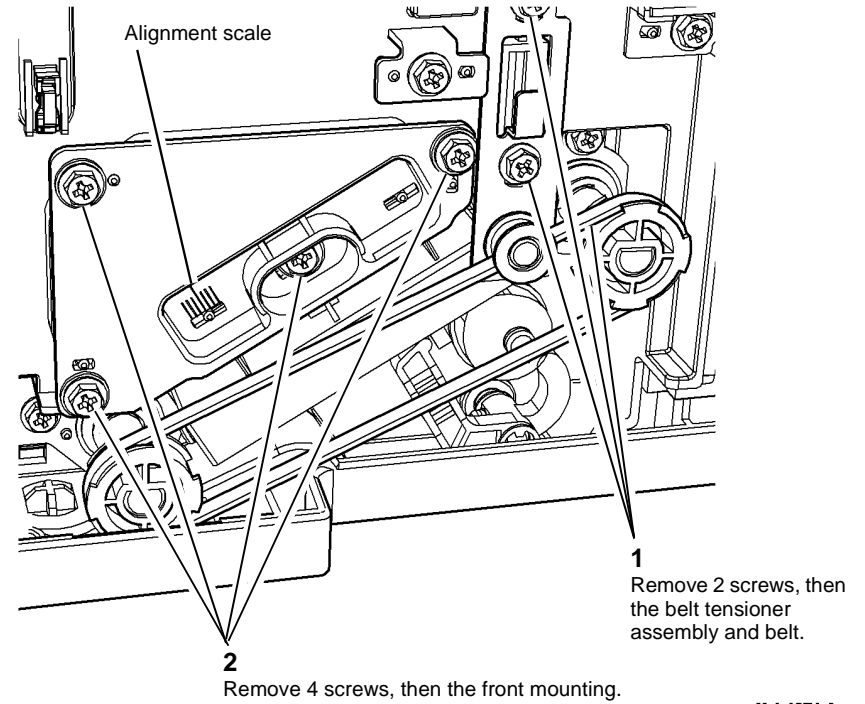
8. Note the position of the peg in the alignment scale, [Figure 2](#).

9. Prepare to remove the side 2 scan assembly, [Figure 2](#).

Figure 2 Preparation 2

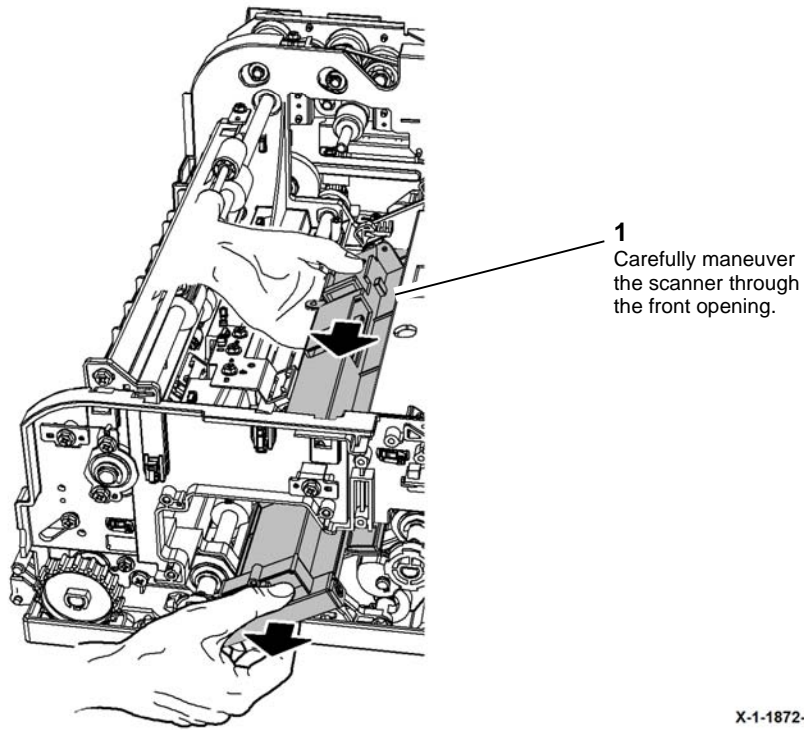
10. Remove the side 2 scan assembly, [Figure 3](#).

Figure 3 Side 2 scan assembly

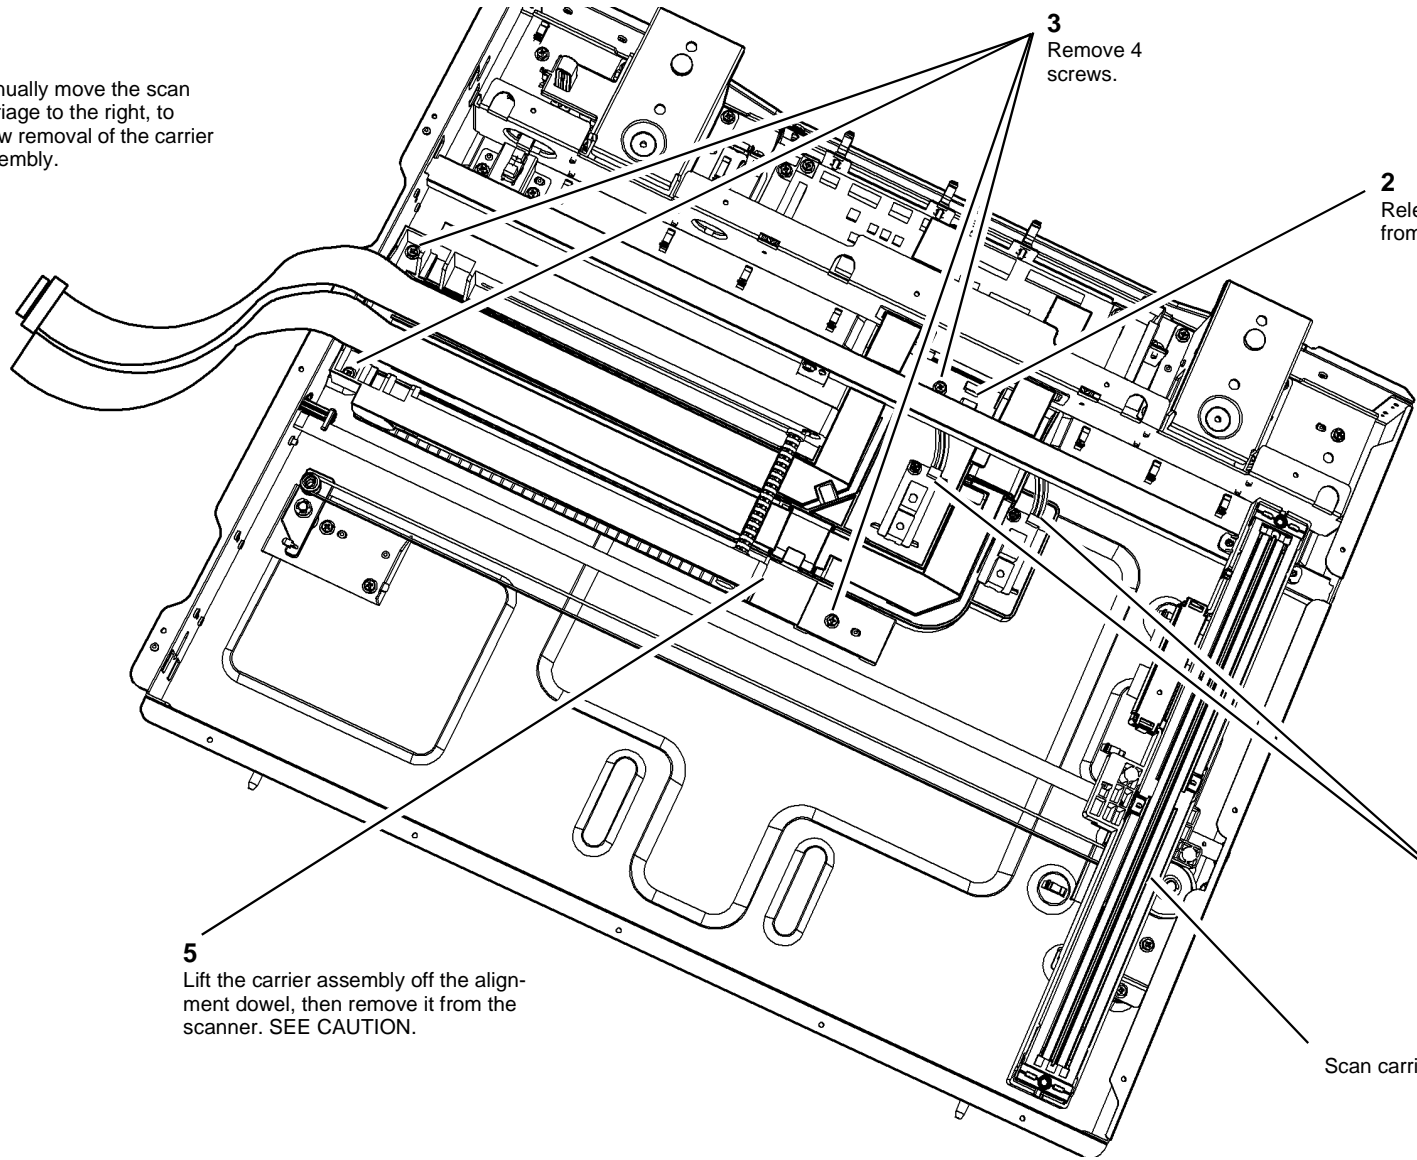
5
Lift the carrier assembly off the alignment dowel, then remove it from the scanner. **SEE CAUTION.**

Figure 1 Carrier removal

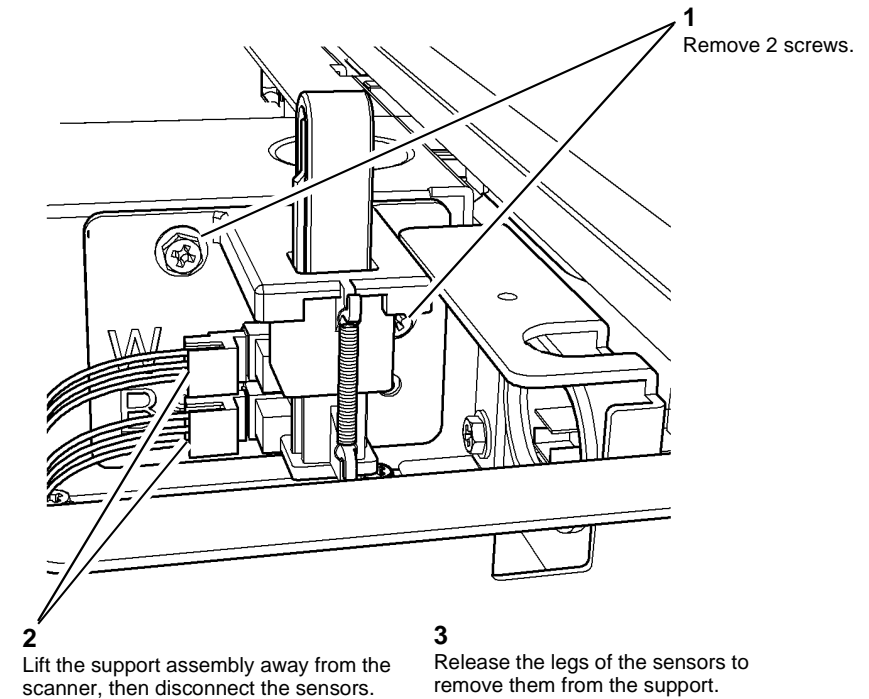
1. Remove the scanner top cover, [REP 60.3](#).
2. Remove the scanner left cover, [PL 60.15](#) Item 7.
3. Remove the actuator support assembly, [Figure 1](#).

Figure 1 Actuator support assembly

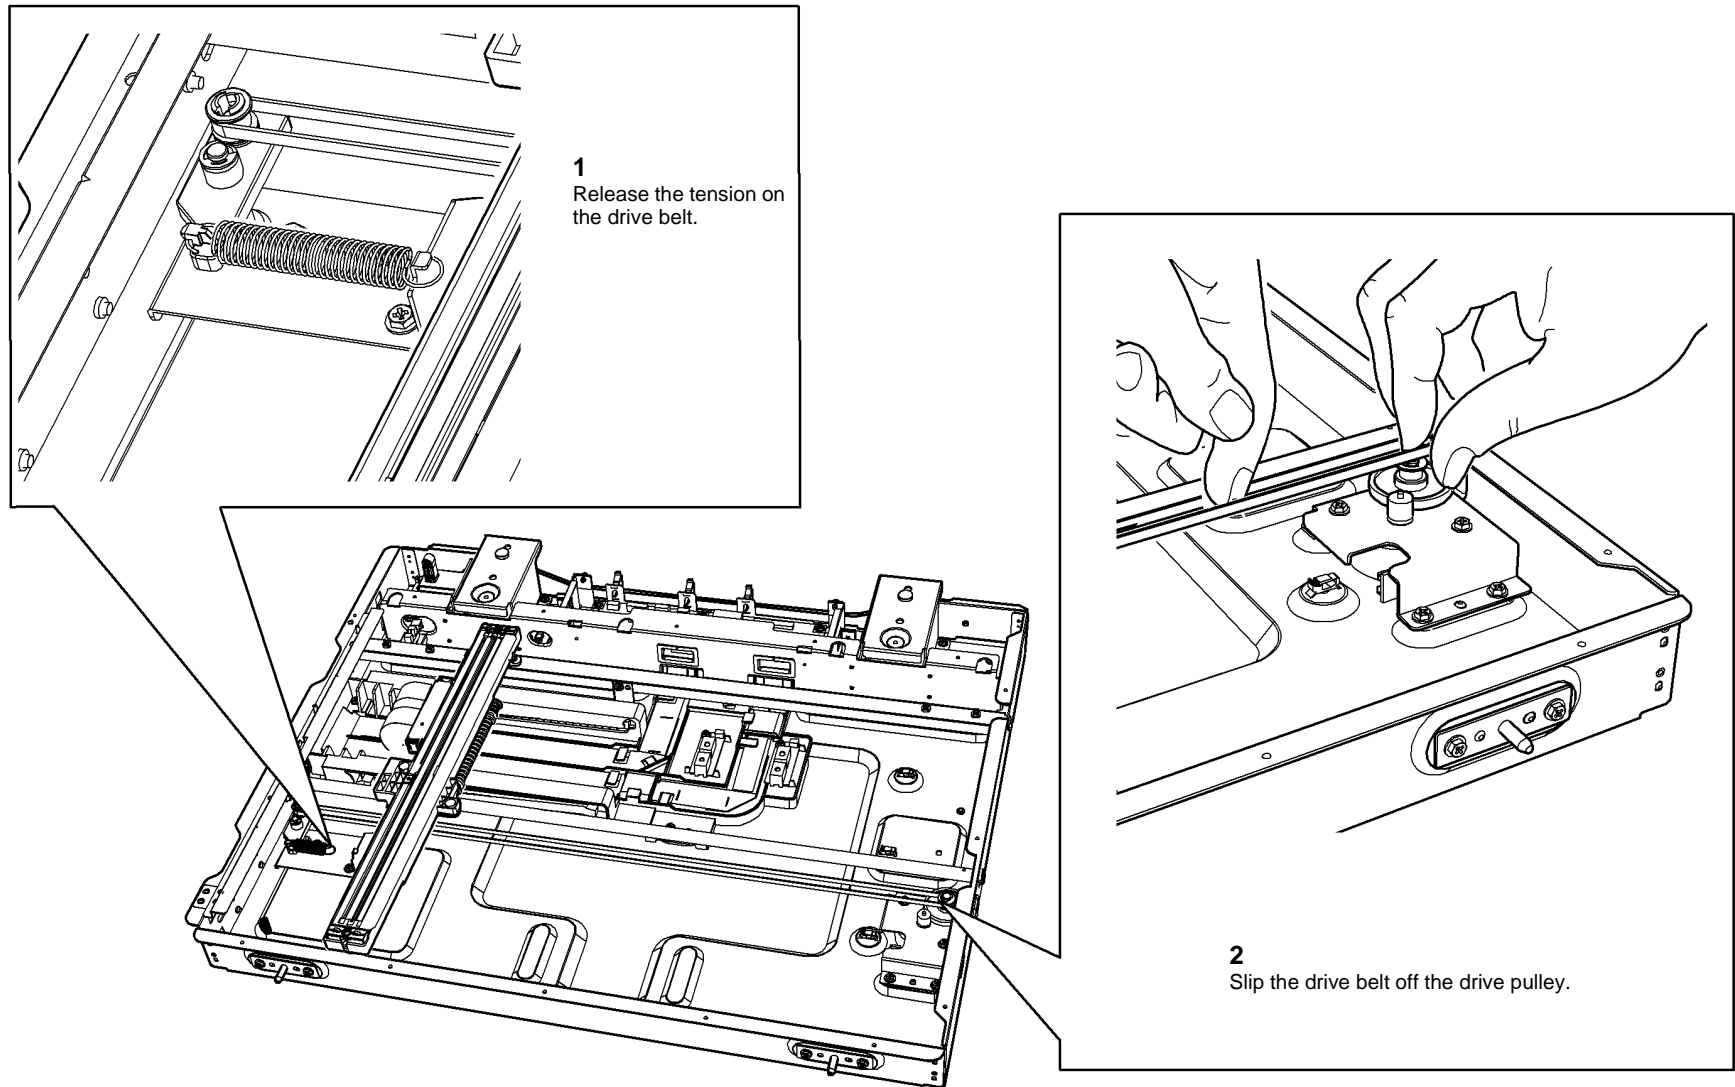
2. Remove the scan carriage drive belt from the motor drive gear, [Figure 1](#).

Figure 1 Drive belt release

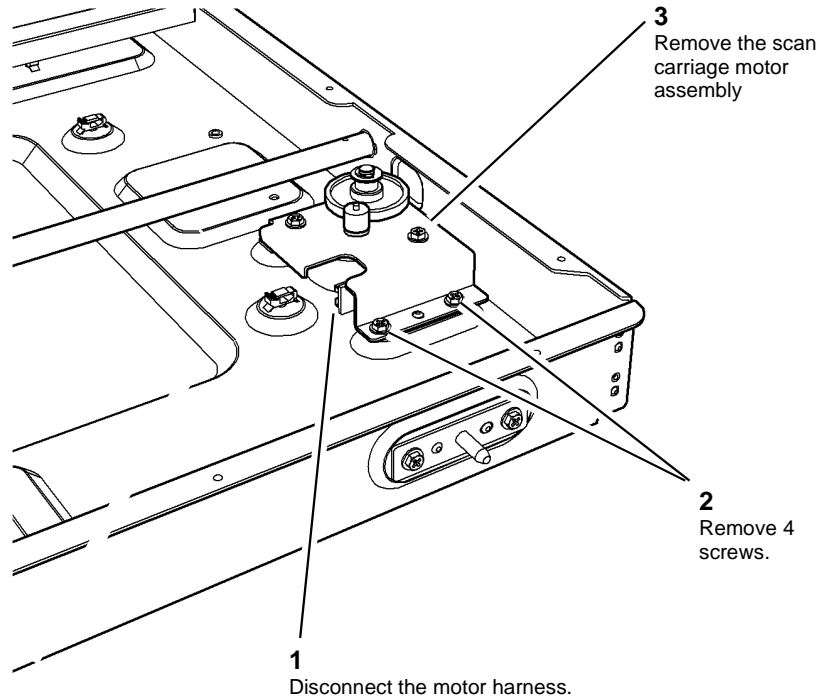
- Remove the scan carriage motor assembly, [Figure 2](#).

Figure 2 Motor and bracket removal

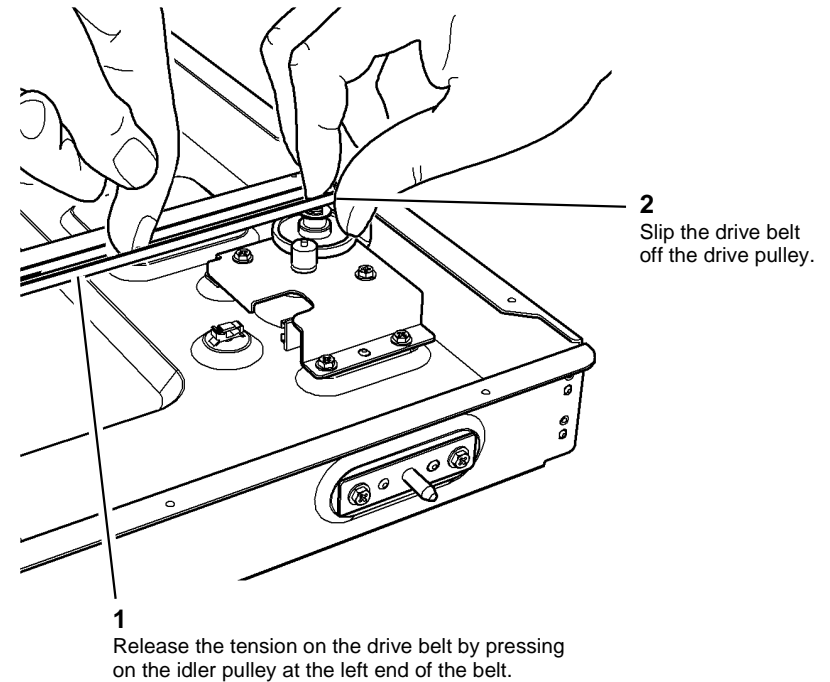
- Remove the top cover assembly, [REP 60.3](#).
- Release the scan carriage drive belt from the scan carriage motor assembly, [Figure 1](#).

Figure 1 Drive belt release

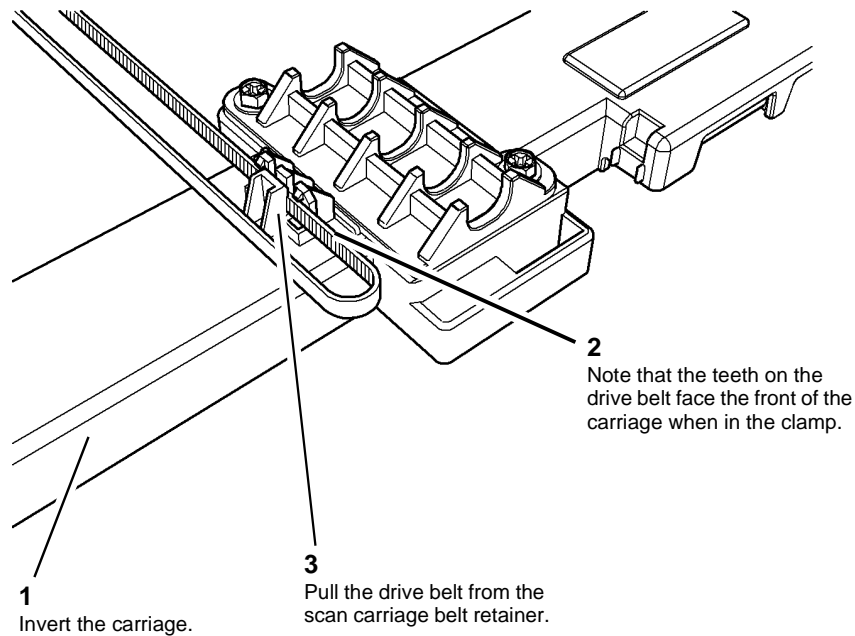
- Detach the scan carriage drive belt, [Figure 2](#).

Figure 2 Drive belt retainer

- The replacement is the reverse of the removal procedure.
- Ensure the scan carriage drive belt is installed correctly in the scan carriage belt retainer, [Figure 2](#).
- Ensure the scan carriage drive belt is installed correctly on the idler pulley and the drive pulley.
- Perform [ADJ 60.1](#) Scanner Cleaning Procedure before installing the top cover assembly.
- Perform [ADJ 60.3](#) IIT Registration, Magnification and Calibration.

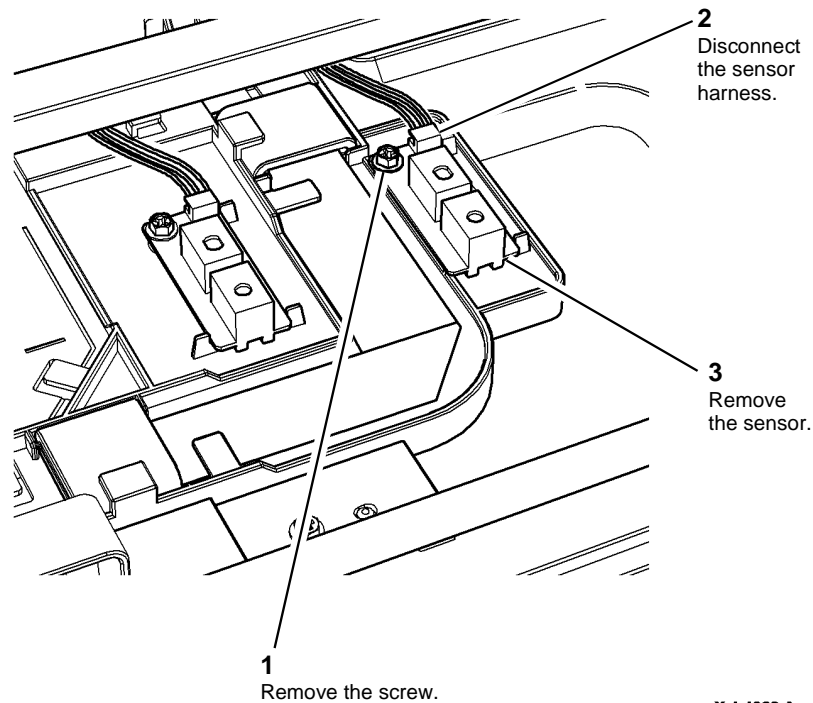
- Remove document size sensor 1 (Q62-251) or document size sensor 2 (Q62-253), [Figure 1](#).

NOTE: The removal procedure of document size sensor 1 and document size sensor 2 is identical.

Figure 1 Document size sensor removal

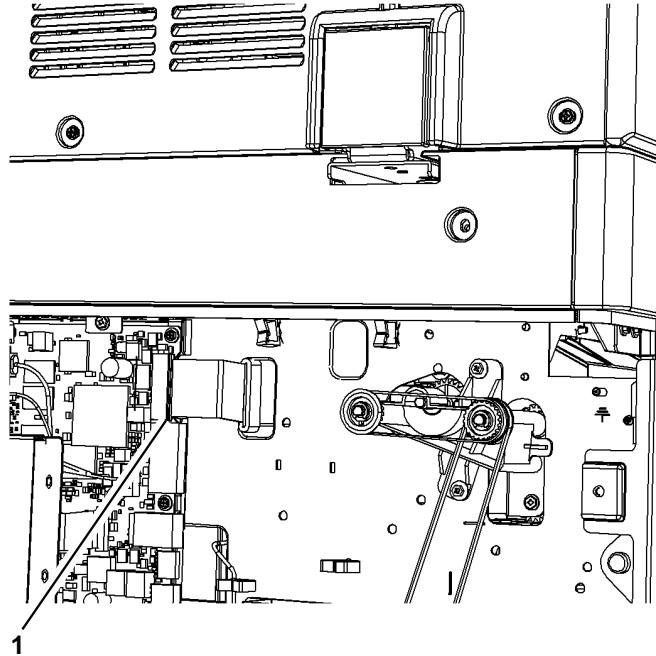
3. Disconnect the LED print head module ribbon cable, [Figure 1](#).

1 Disconnect the LPH ribbon cable from PJ851 on the SBC PWB.

Figure 1 Ribbon cable

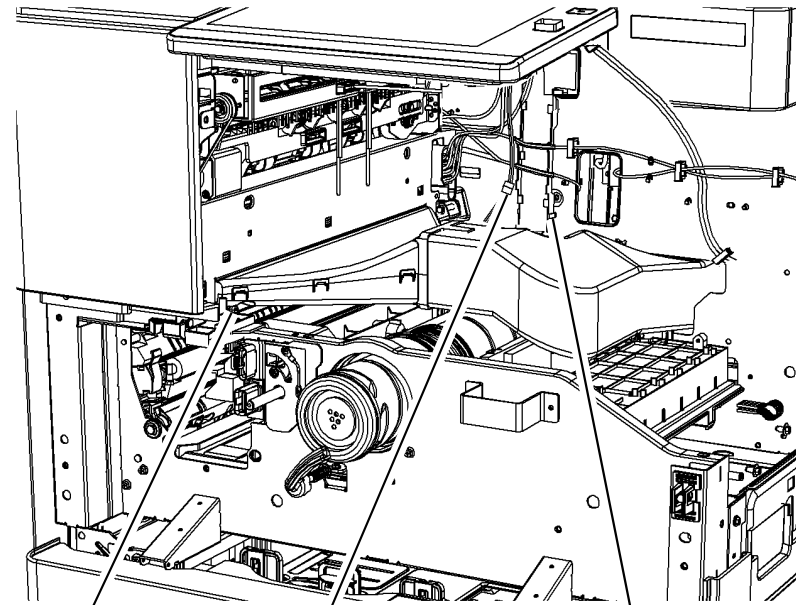
10. Prepare to remove the LED print head module, [Figure 2](#).

1 Disconnect the in-line connector of the CRUM connectors assembly (front).

2 Disconnect the in-line connector of the CRUM connectors assembly (rear).

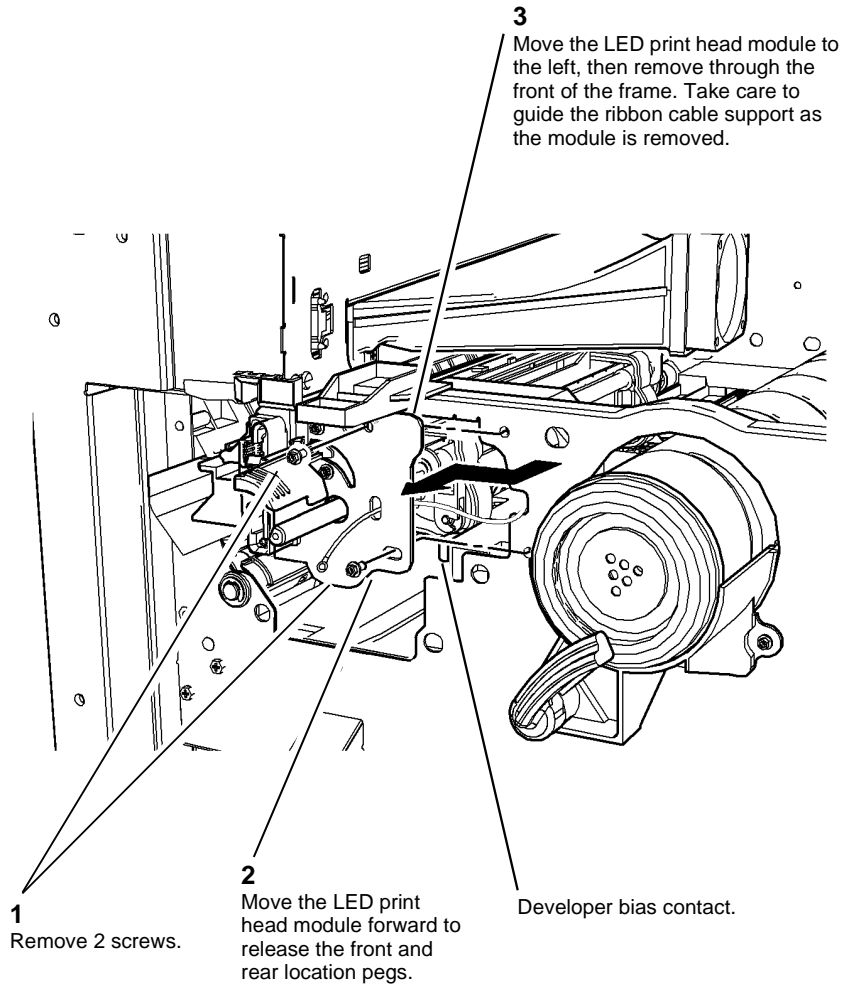
11. Remove the LED print head module, **Figure 3**.

13. Remove the ferrite from the ribbon cable.
14. Un-fold the uppermost corner fold in the ribbon cable.
15. Slide the ribbon cable out of the support.

Figure 3 LPH removal

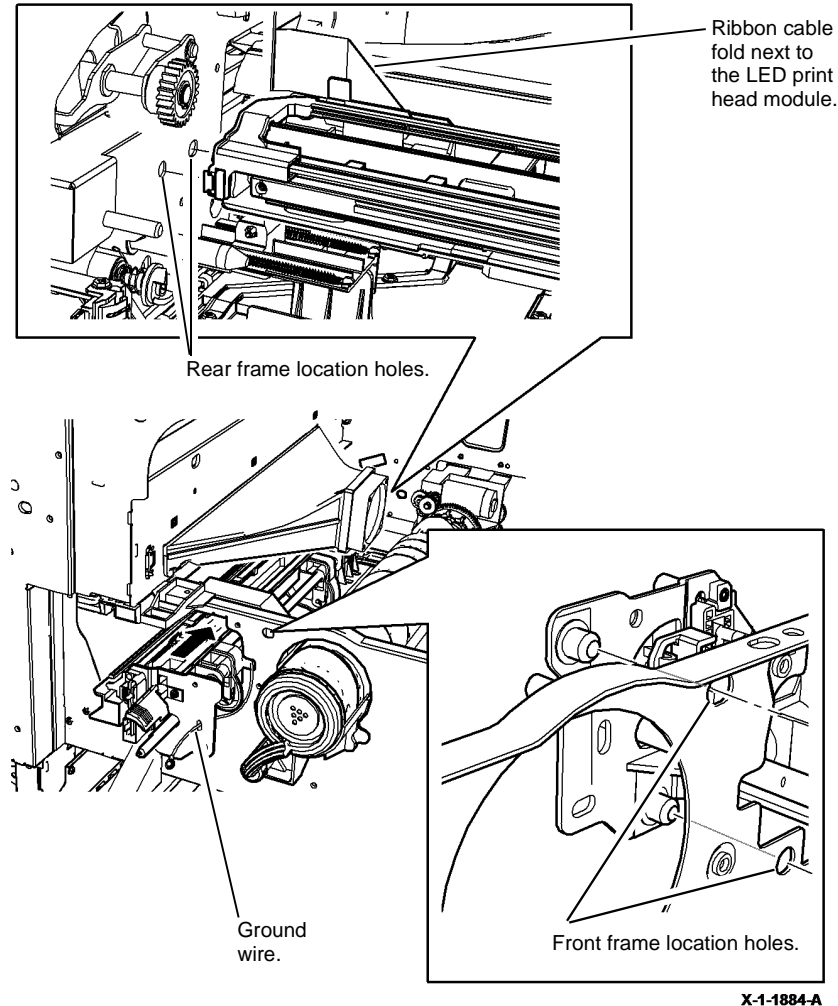
1. The replacement is the reverse of the removal procedure.
2. Before installing the new LED print head module, ensure that the LED print head cleaner is fully home and the LED lamp is cammed into the housing.
3. Ensure the front and rear location pegs on the LPH are aligned with the holes in the frame, [Figure 4](#).

Figure 4 Replacement

4. Ensure that any slack in the ground wire is positioned behind the machine frame, not in front, [Figure 4](#).

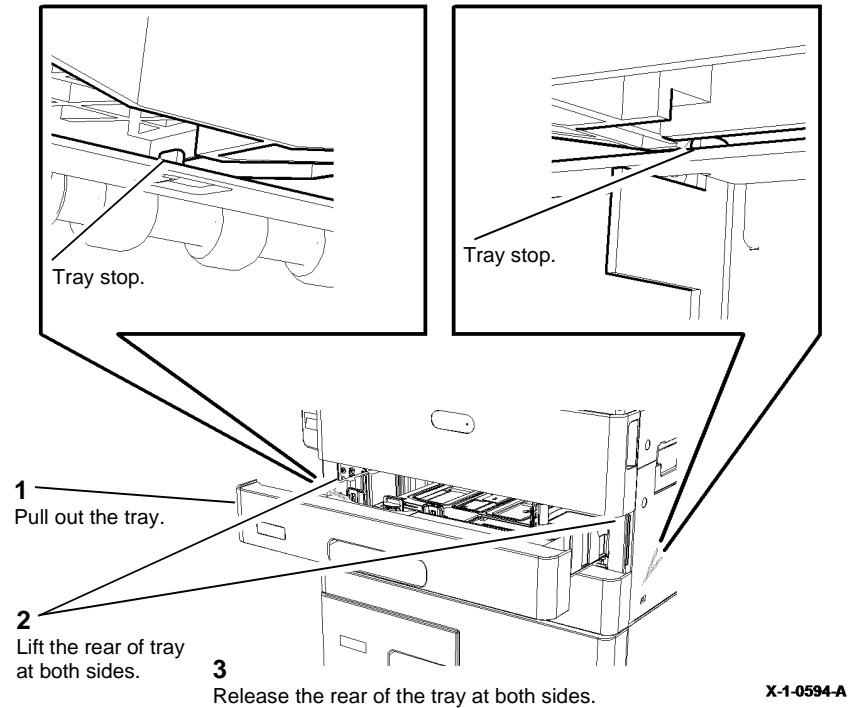
1. Remove tray 1 or tray 2, [Figure 1](#).

Figure 1 Tray 1 and tray 2 removal

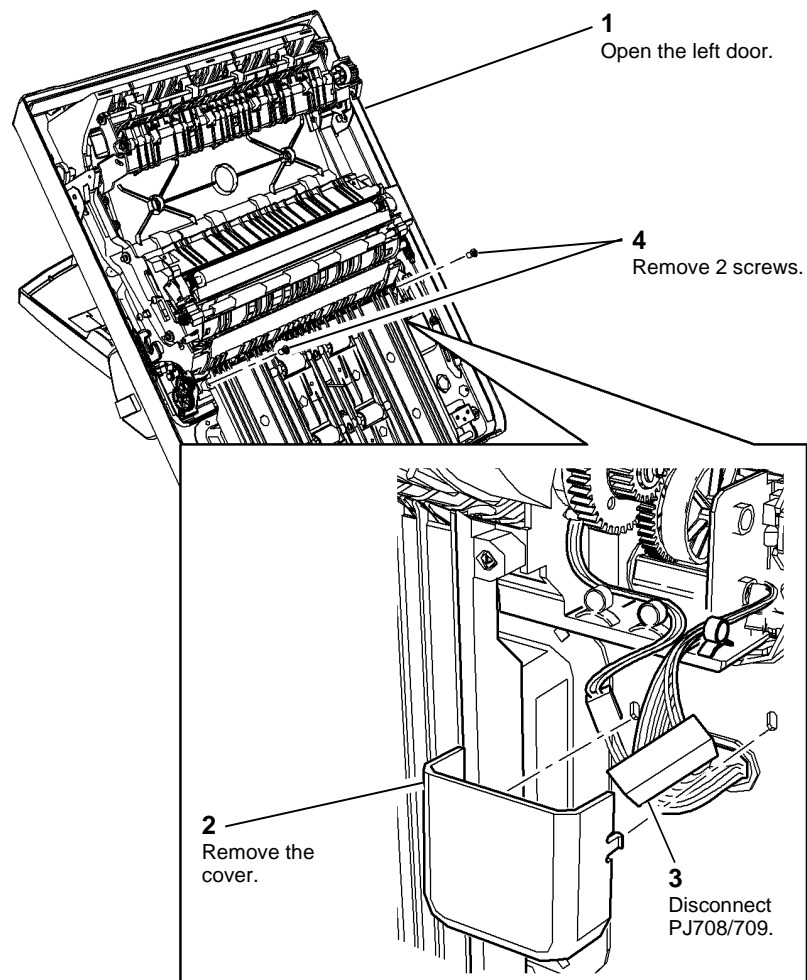
2. Prepare to remove the bypass tray assembly, [Figure 1](#).

Figure 1 Preparation

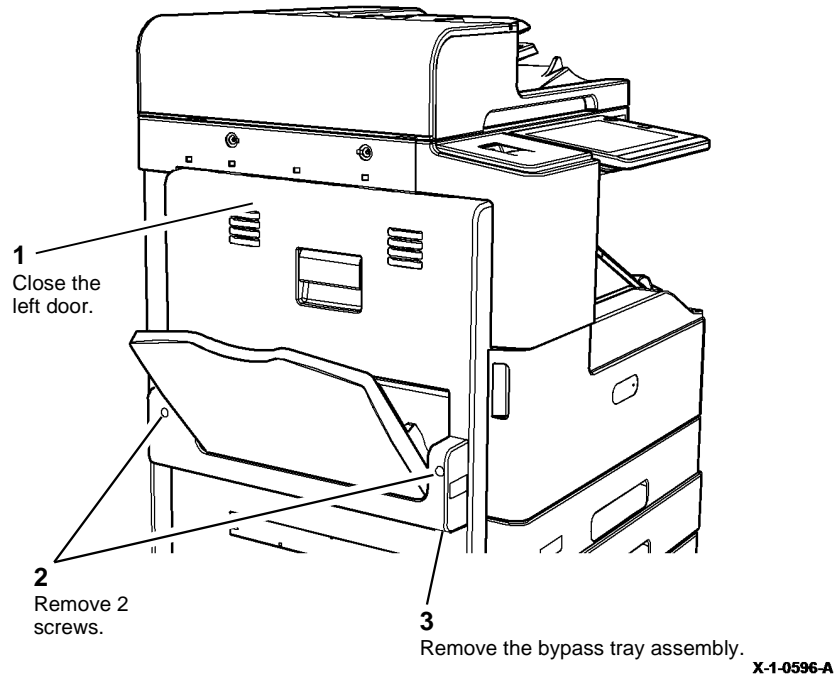
3. Remove the bypass tray assembly, [Figure 2](#).

Figure 2 Bypass tray removal

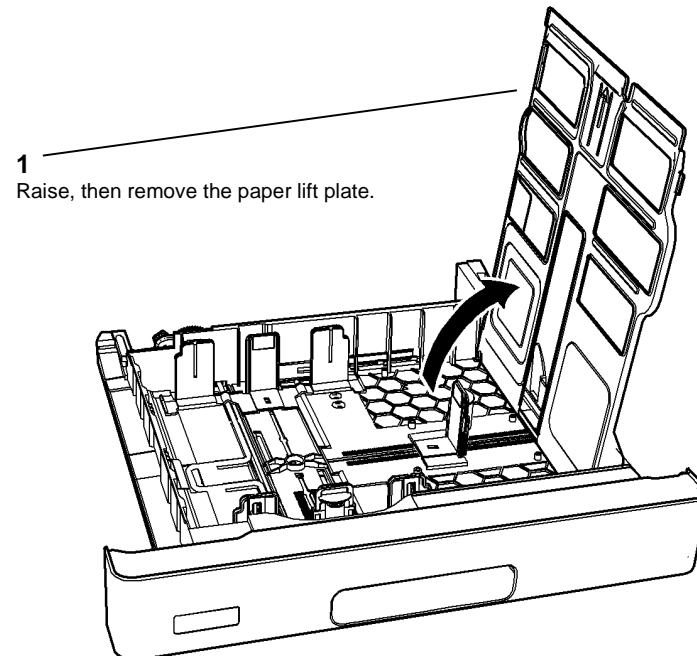
1. Remove the paper from the tray.
2. Remove the tray, [REP 70.1](#).
3. Remove the paper lift plate, [Figure 1](#).

Figure 1 Paper lift plate removal

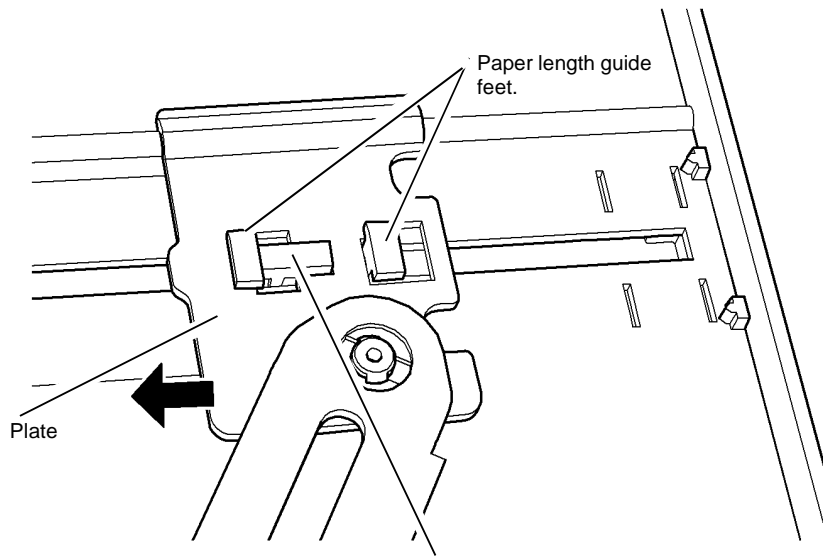
- 1** Remove the tab using a small flat blade screwdriver under the centre of the tab.
- 2** Move the plate to the left to release the plate from the length guide.

Figure 2 Preparation

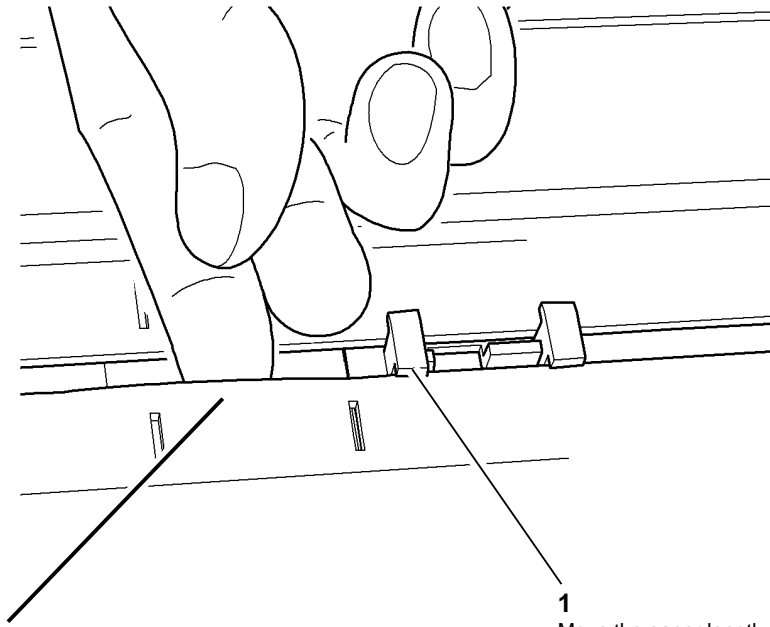
- 2** Lift one side of the track to prise the paper length guide out of the track.

Figure 3 Paper length guide removal

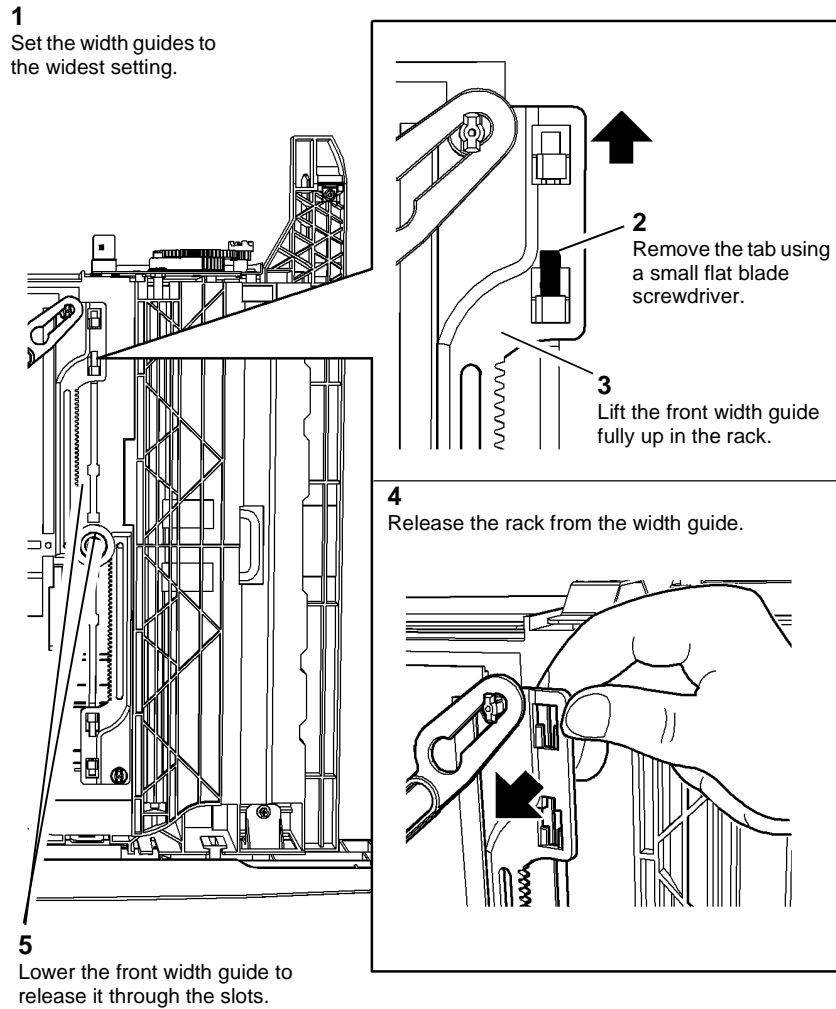
6. Remove the front paper width guide, [Figure 4](#).

Figure 4 Front width guide removal

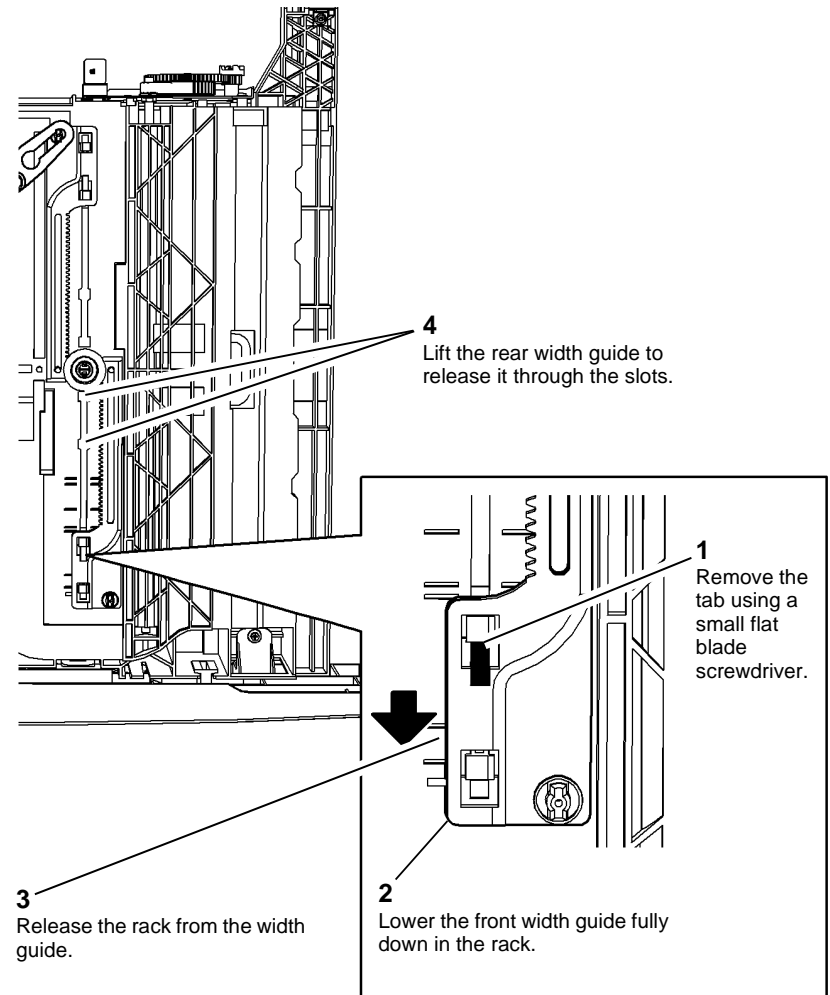
7. Remove the rear paper width guide, [Figure 5](#).

Figure 5 Rear width guide removal

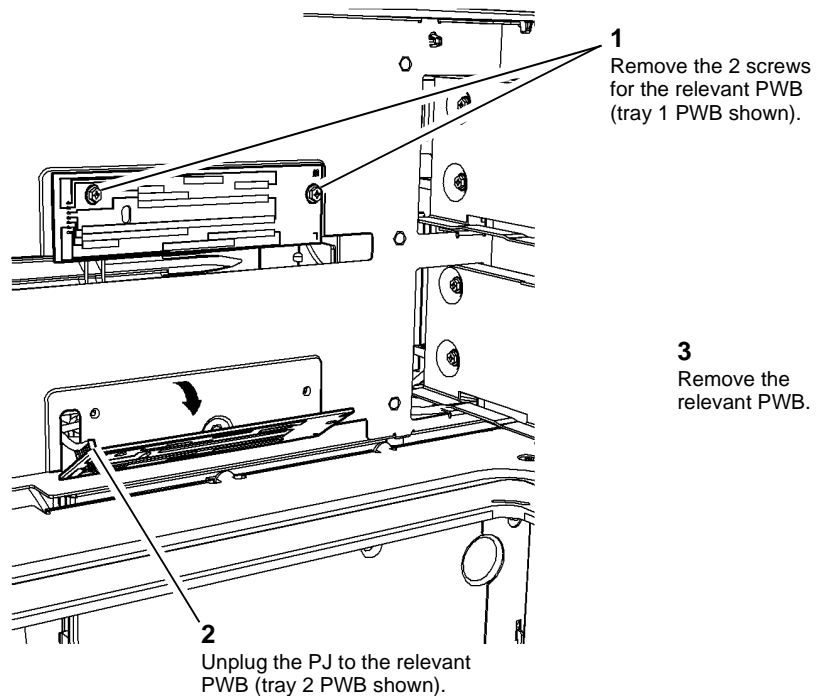
1. Remove tray 1 and tray 2, [REP 70.1](#).
2. Remove the relevant paper tray size sensing PWB, [Figure 1](#).

Figure 1 PWB removal

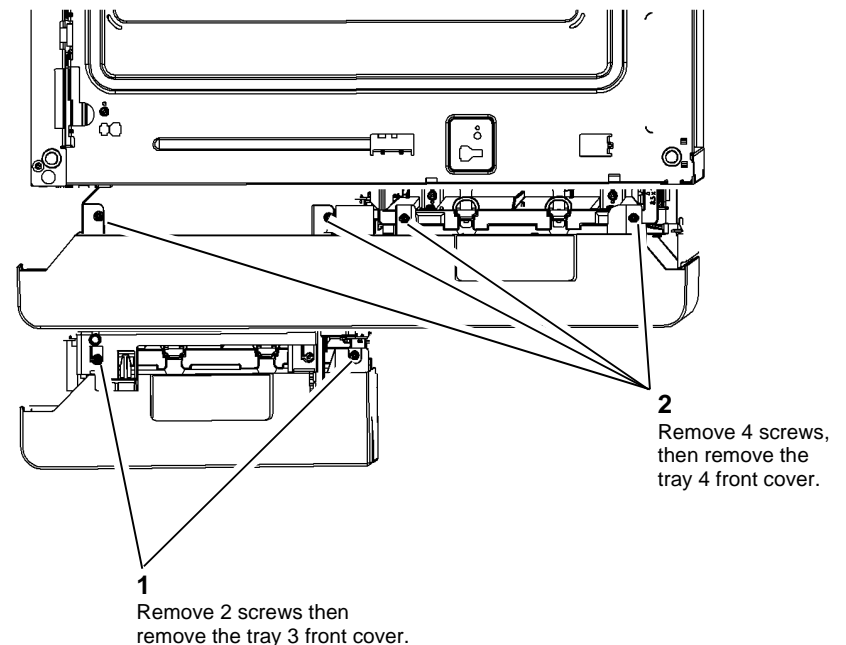
1. Remove the paper from tray 3.
2. Remove the tray 3 and tray 4 front covers, [Figure 1](#).

Figure 1 Tray front covers removal

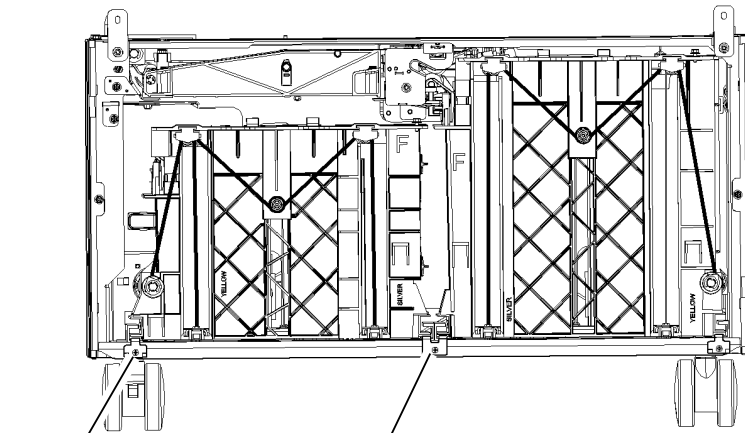
3. Remove the stops, [Figure 2](#).

2 Remove the screw and the left stop (tray 3).

1 Remove the screw and the centre stop.

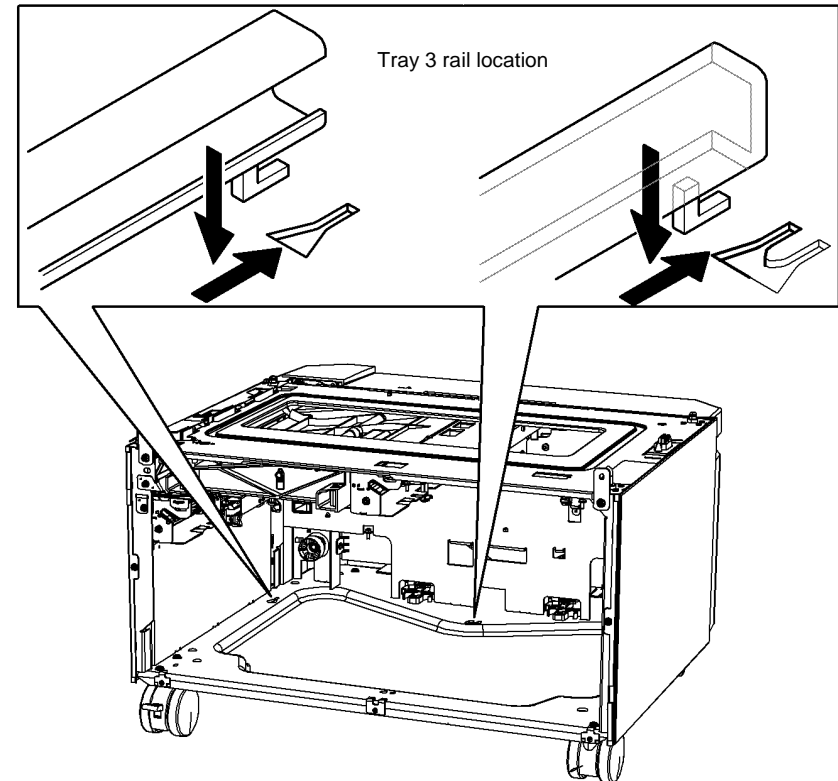
NOTE: When installing tray 3 ensure that the tray rails are located correctly in the base of the machine, [Figure 3](#).

Figure 3 Location of the tray rails

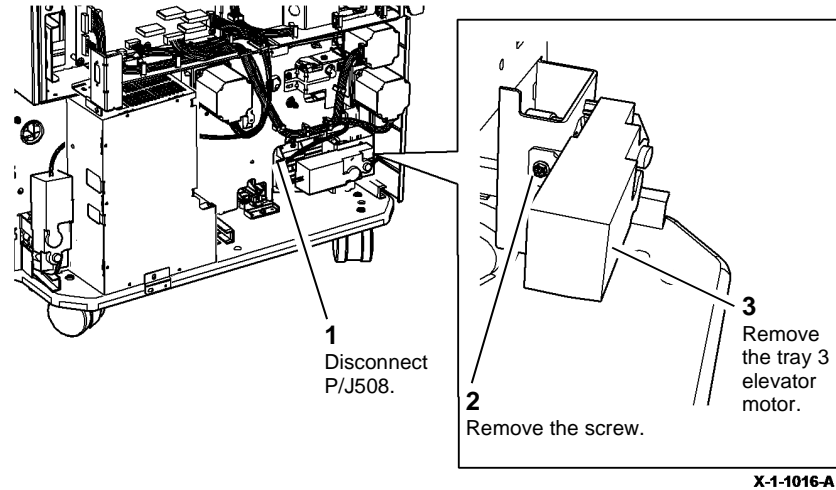
1. Pull out tray 3.
2. Remove the lower rear cover, [PL 70.26 Item 1](#).
3. Remove the tray 3 elevator motor, [Figure 1](#).

Figure 1 Elevator motor removal
