708P91368
September 2017

Xerox® AltaLink® B8090 Family Multifunction Printer Service Manual

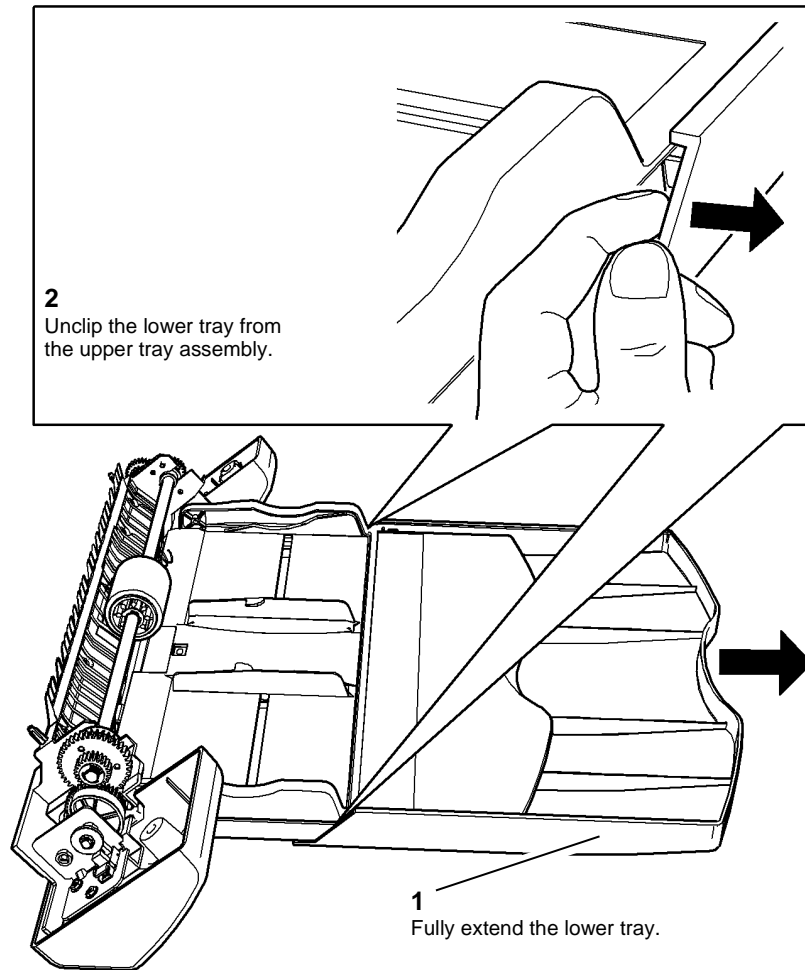
X-1-1119-A

2. Remove the lower tray, [Figure 1](#).

Figure 1 Lower tray removal

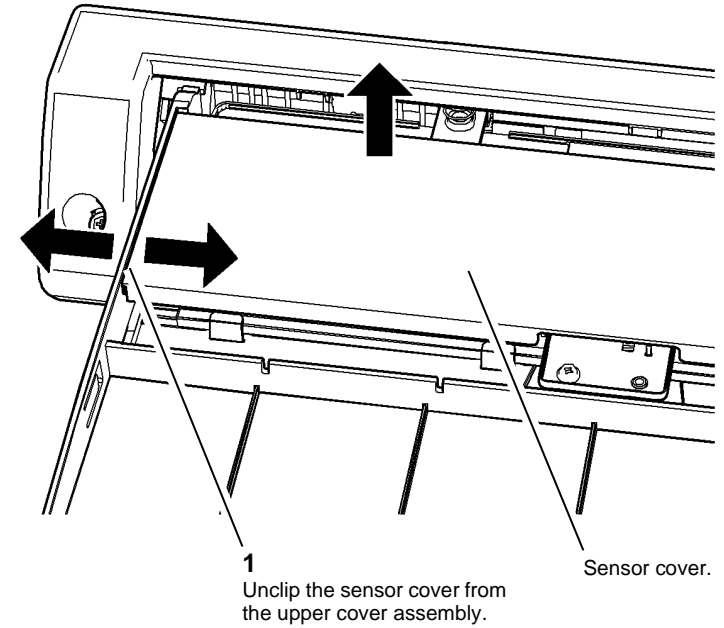
X-1-1120-A

3. Remove the width sensor cover, [Figure 2](#).

Figure 2 Width sensor cover removal

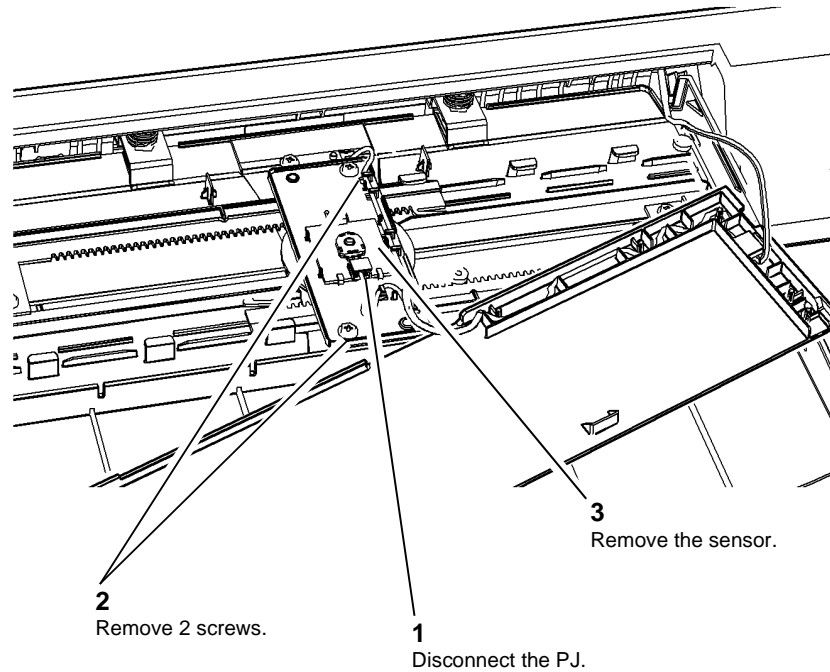
X-1-1121-A

4. Remove the width sensor, [Figure 3](#).

Figure 3 Width sensor removal

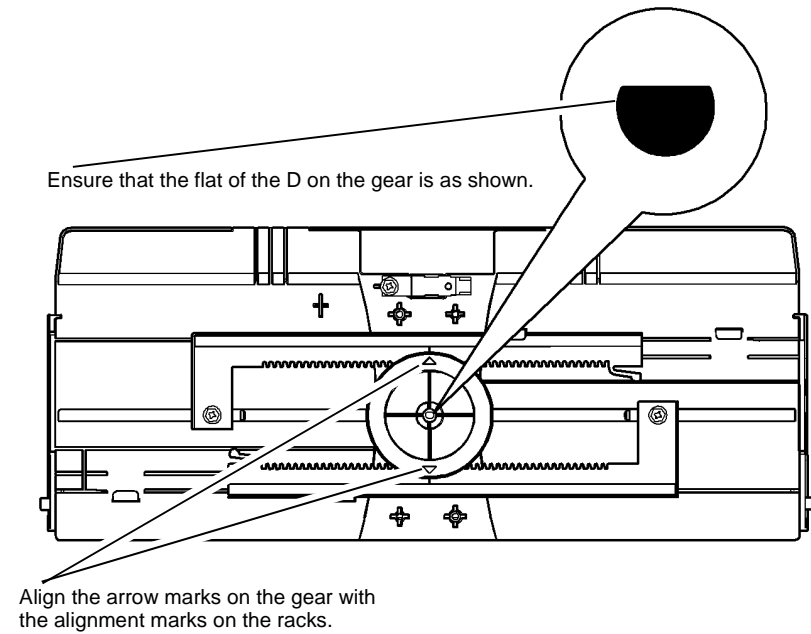
1. The replacement is the reverse of the removal procedure. Refer to [GP 6](#) when refitting the screws securing the sensor.
2. Ensure the potentiometer and gear are correctly aligned with the racks on the size guides, [Figure 4](#).

Ensure that the flat of the D on the gear is as shown.

Align the arrow marks on the gear with the alignment marks on the racks.

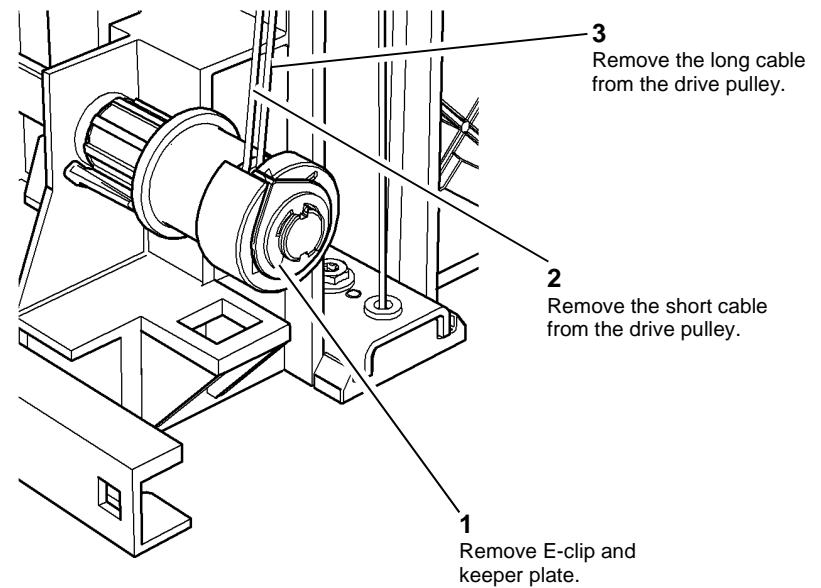
X-1-0632-A

2. Release the cables from the appropriate front drive pulley, [Figure 1](#).

This illustration shows tray 3 front.

Figure 1 Front cables release

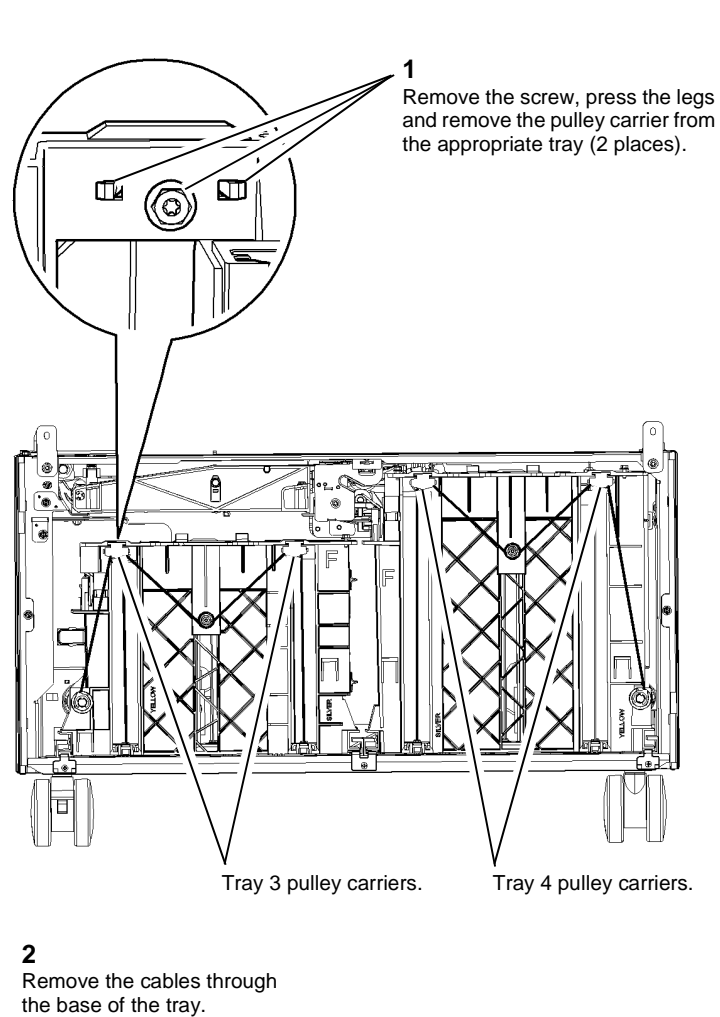
X-1-0633-A

NOTE: The short cable is located over the outer pulley and the long cable is located over the inner pulley.

Figure 2 Front cables removal

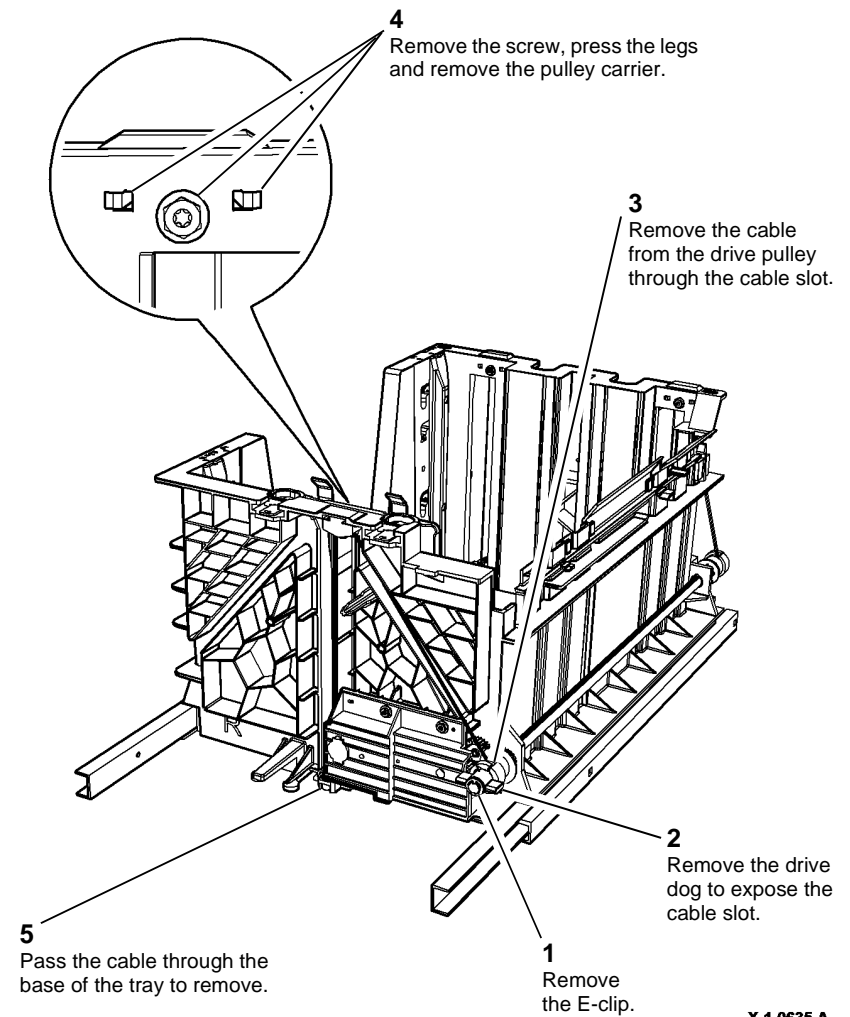
X-1-0635-A

Figure 3 Tray 3 rear cable removal

1. The replacement is the reverse of the removal procedure.
2. For the tray 3 front cables:
 - a. Thread the long cable over the inner groove on the pulley.
 - b. Thread the short cable over the outer groove on the pulley.
3. For the tray 3 rear cable, thread the medium length cable over the outer groove on the pulley.
4. For the tray 4 front cables:
 - a. Thread the short cable over the inner groove on the pulley.
 - b. Thread the long cable over the outer groove on the pulley.
5. For the tray 4 rear cable, thread the medium length cable over the inner groove on the pulley.

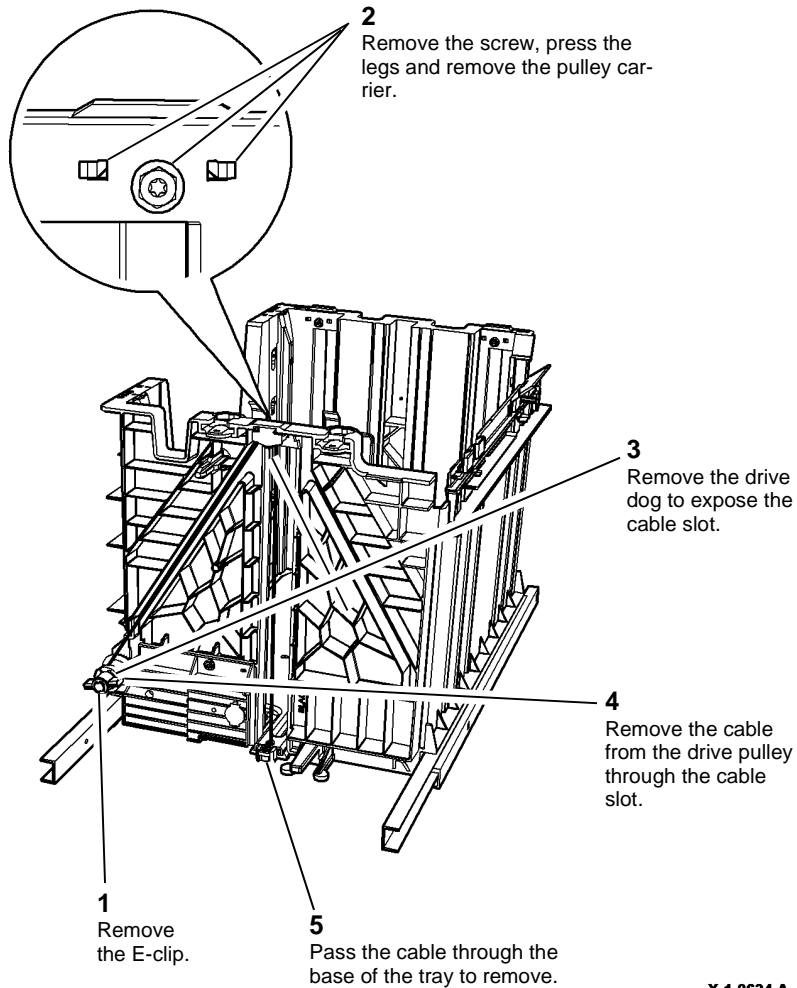
X-1-0634-A

Figure 4 Tray 4 rear cable removal

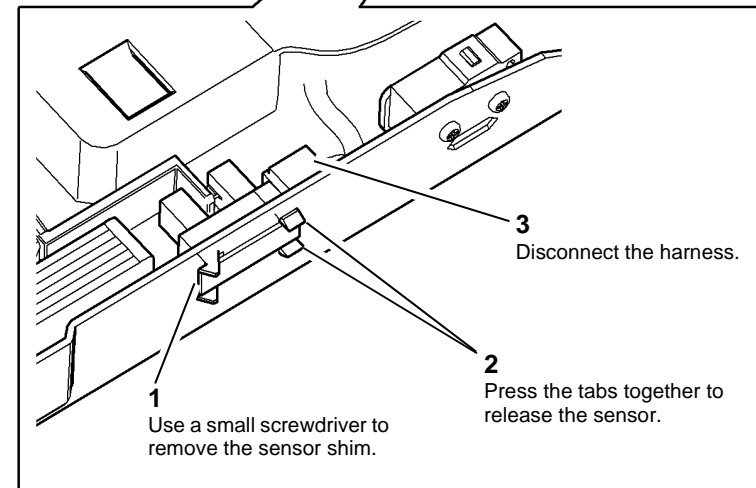
X-1-0636-A

Figure 1 Stack height sensor removal

The replacement is the reverse of the removal procedure. Install a new sensor shim to lock the sensor in place.

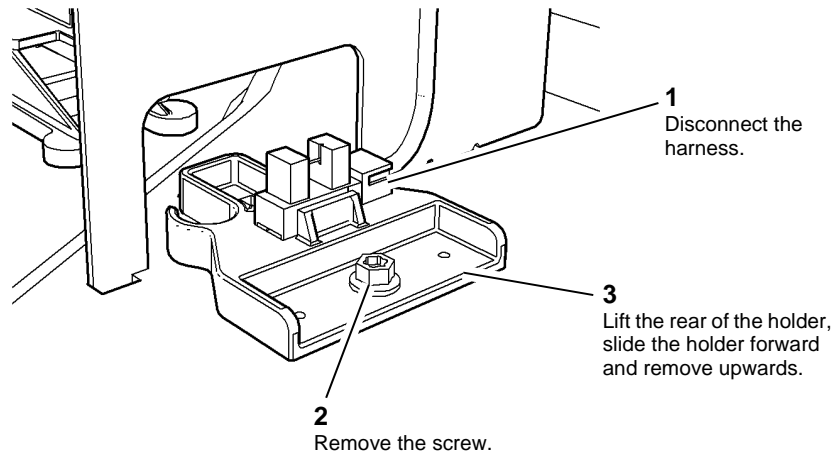
X-1-0637-A

1. Pull out tray 3 or tray 4 by approximately 50mm (2 inches).
2. Remove the lower rear cover, [PL 70.26 Item 1](#).
3. If removing the tray 4 home sensor, remove the LVPS, [REP 1.1](#).
4. Remove the tray home sensor and holder, [Figure 1](#).

Figure 1 Tray home switch and holder

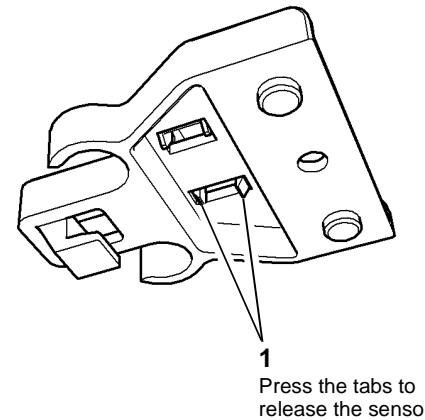
X-1-0638-A

Figure 2 Sensor removal

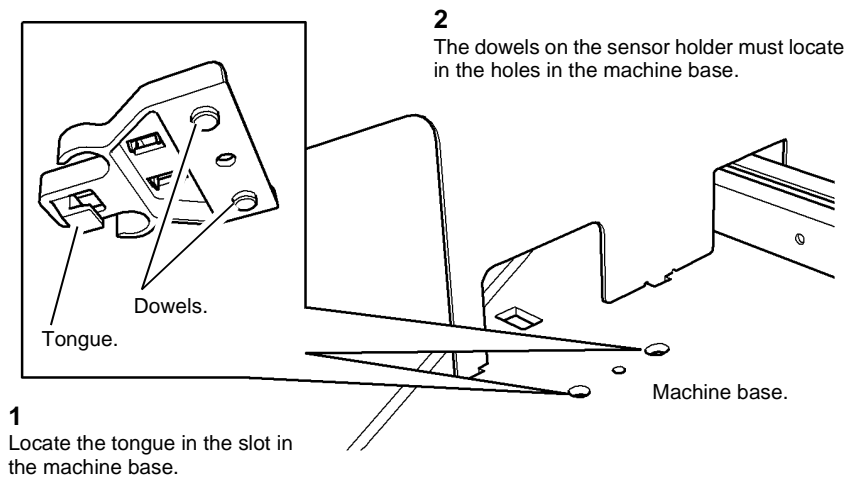
X-1-0639-A

Replacement is the reverse of the removal procedure. Correctly locate the sensor holder, [Figure 3](#).

Figure 3 Holder location

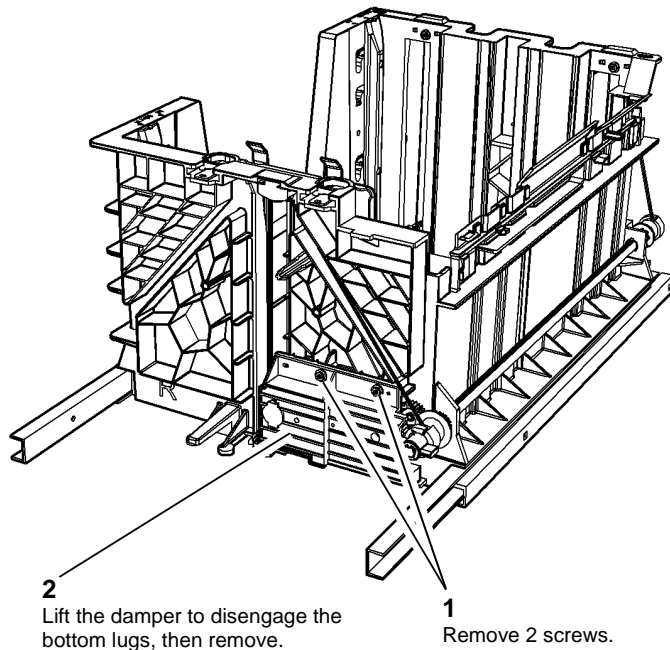
2 Lift the damper to disengage the bottom lugs, then remove.

1 Remove 2 screws.

Figure 1 Tray 3 damper removal

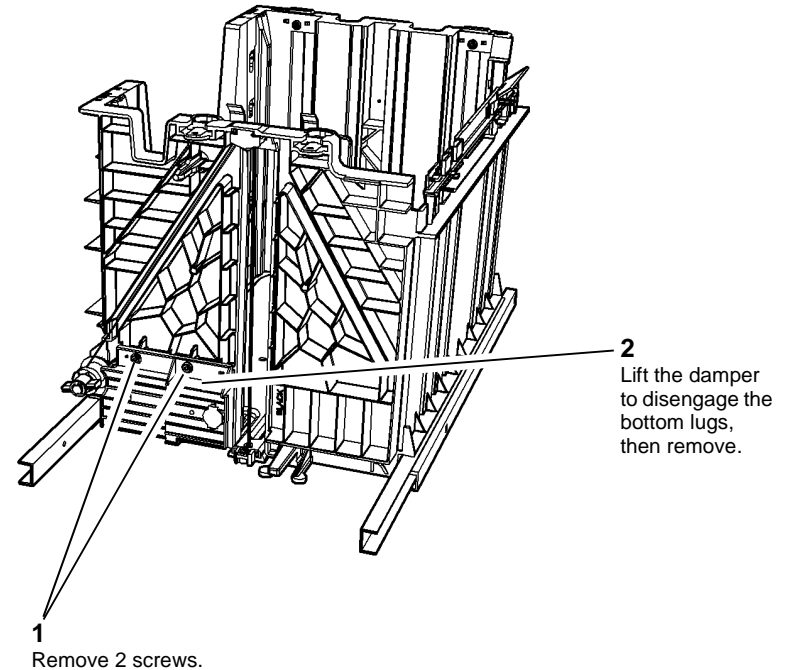
3. Remove the damper from tray 4, [Figure 2](#).

1 Remove 2 screws.

2 Lift the damper to disengage the bottom lugs, then remove.

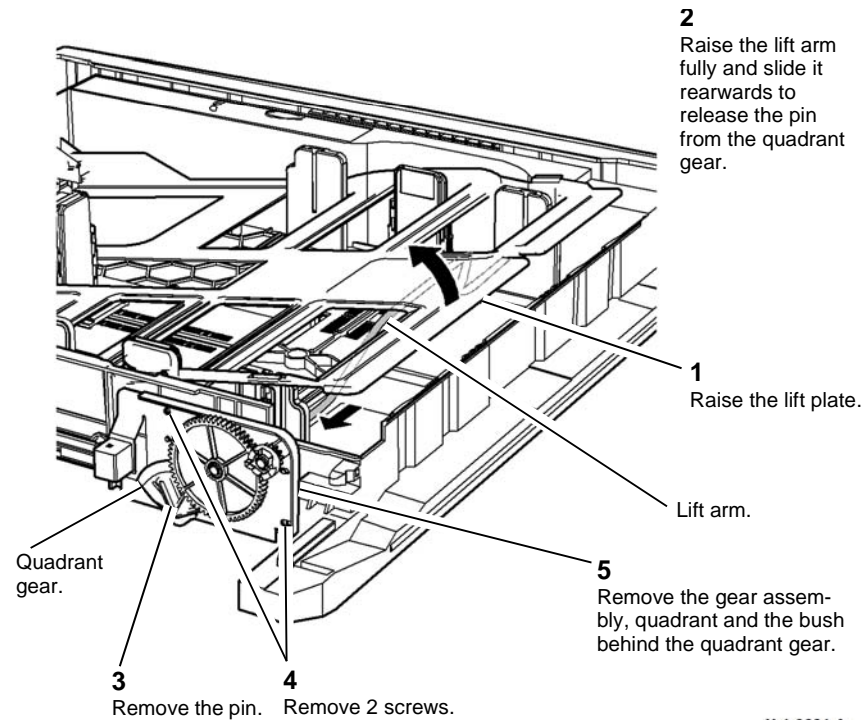
X-1-0621-A

NOTE: Make a note of the position of the 2 screws on the gear assembly, for replacement purposes.

Figure 1 Lift gear removal

1. Engage the lift gear assembly with the spigots on the rear of the tray. The remainder of the replacement procedure is the reverse of the removal procedure.

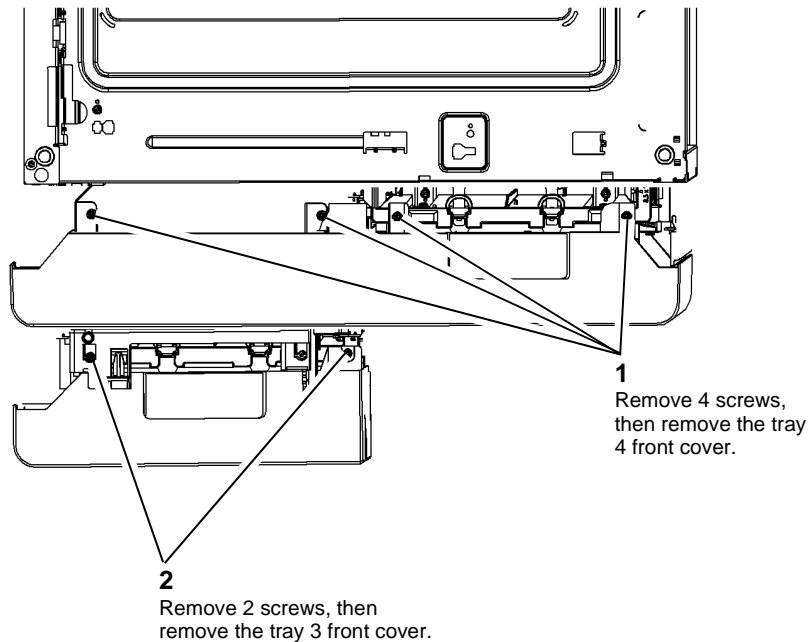
X-1-1014-A

Figure 1 Front covers removal

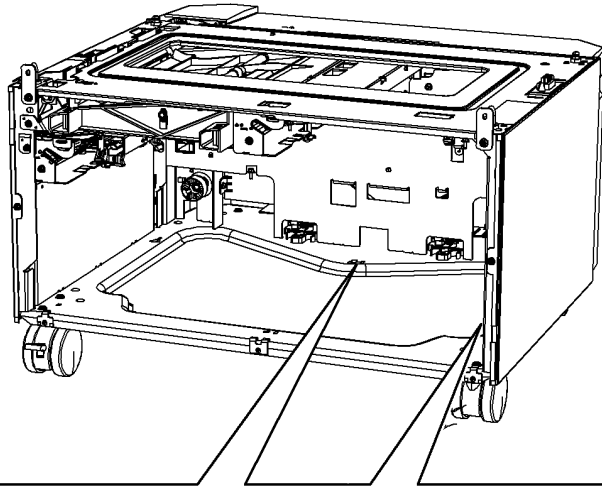
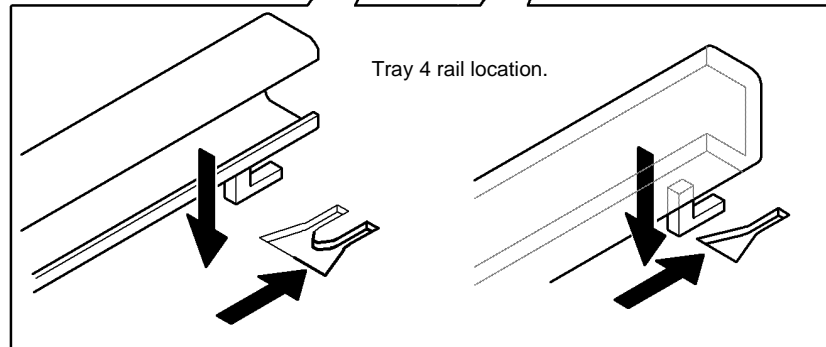
X-1-1013-A

NOTE: When installing tray 4 ensure that the tray rails are located correctly in the base of the machine, [Figure 3](#).

Figure 3 Location of the tray rails

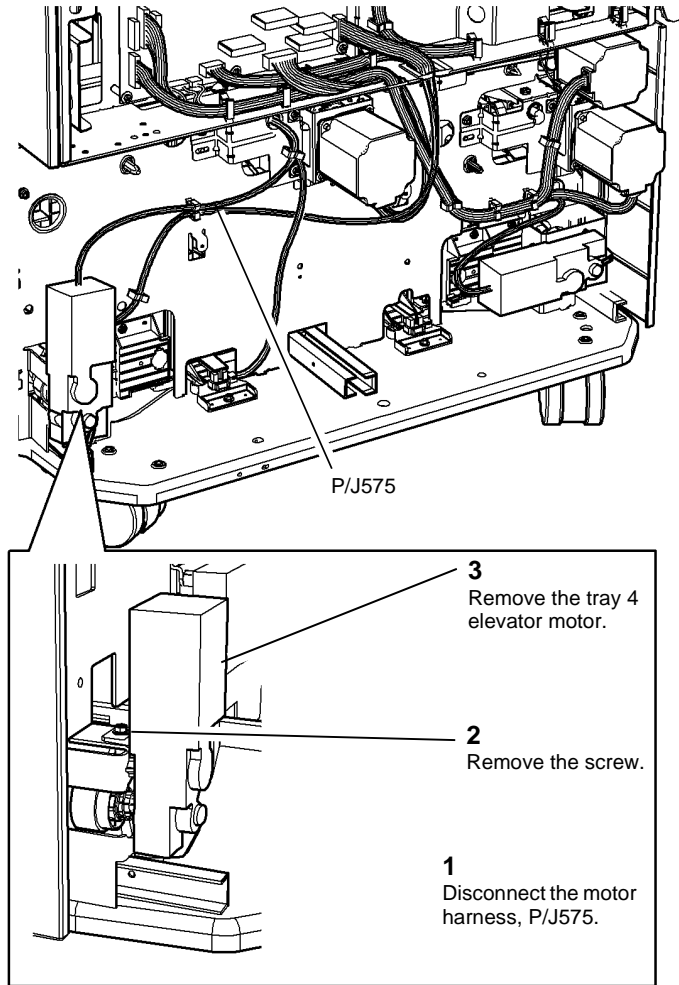
- Remove the tray 4 elevator motor, [Figure 1](#).

Figure 1 Elevator motor removal

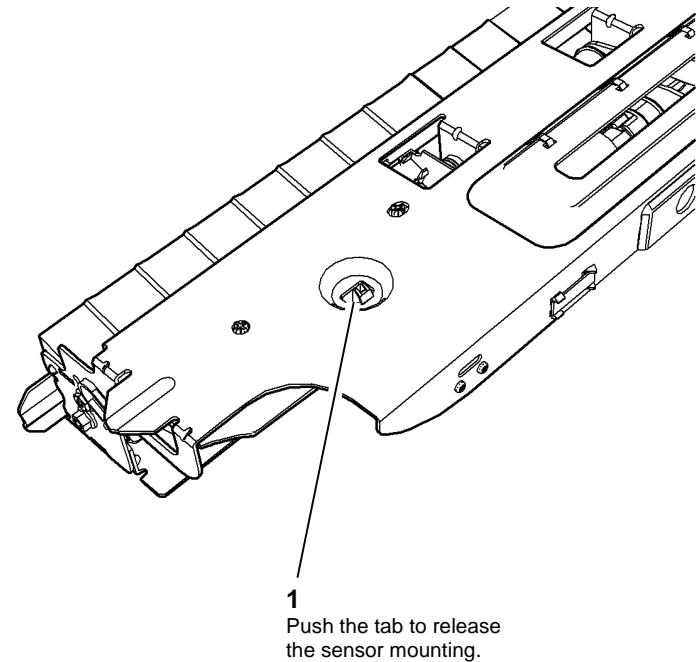
X-1-1431-A

Figure 1 Sensor mounting release

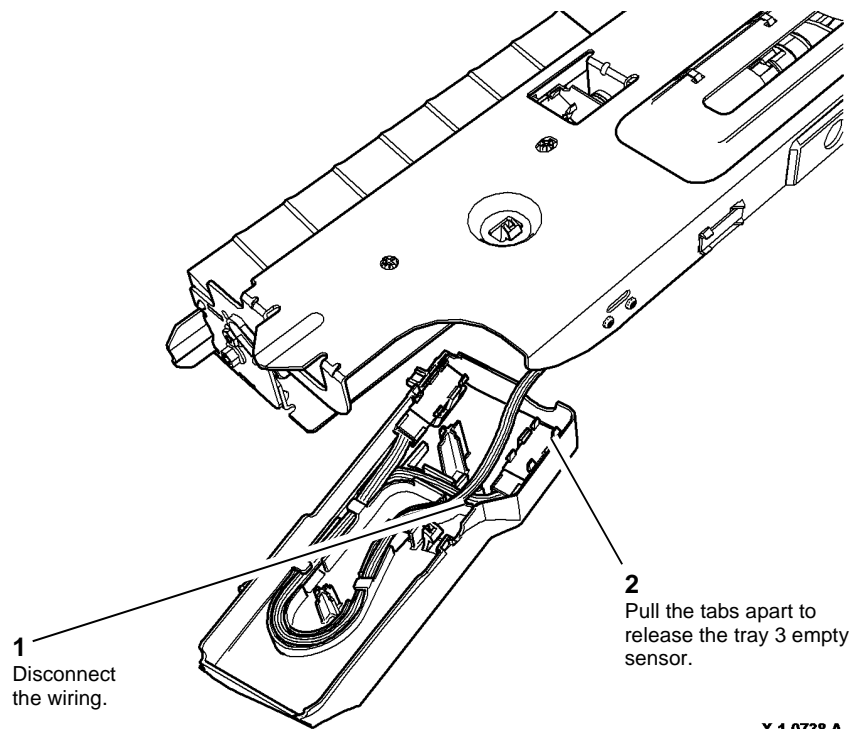
X-1-0738-A

3. Remove the tray 3 empty sensor, [Figure 2](#).

Figure 2 Sensor removal

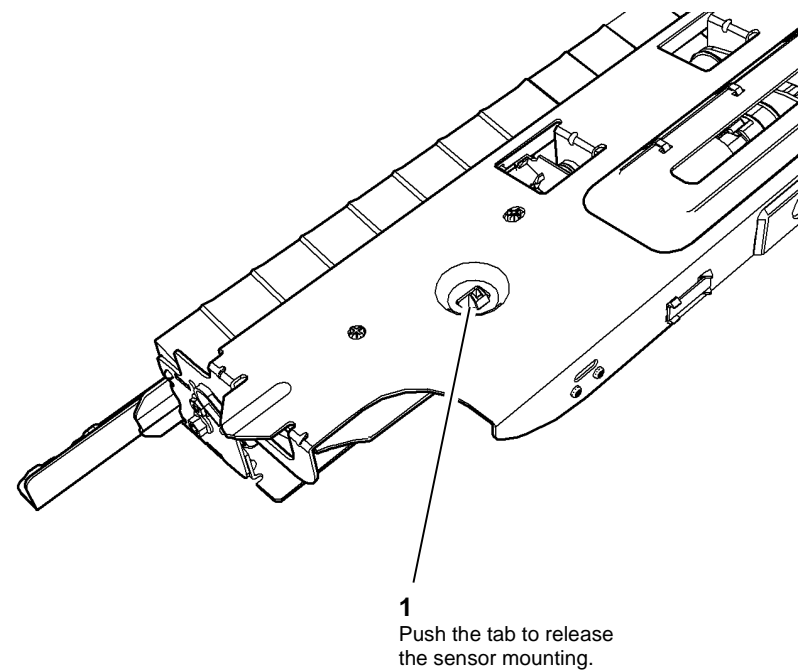
X-1-0732-A

Figure 1 Sensor mounting release

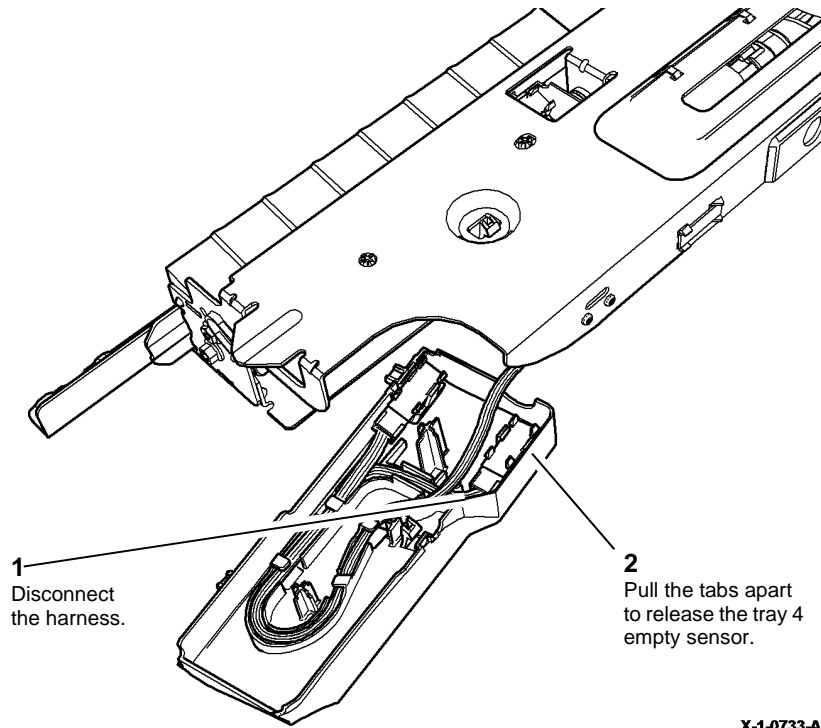
X-1-0733-A

3. Remove the tray 4 empty sensor, [Figure 2](#).

Figure 2 Sensor removal

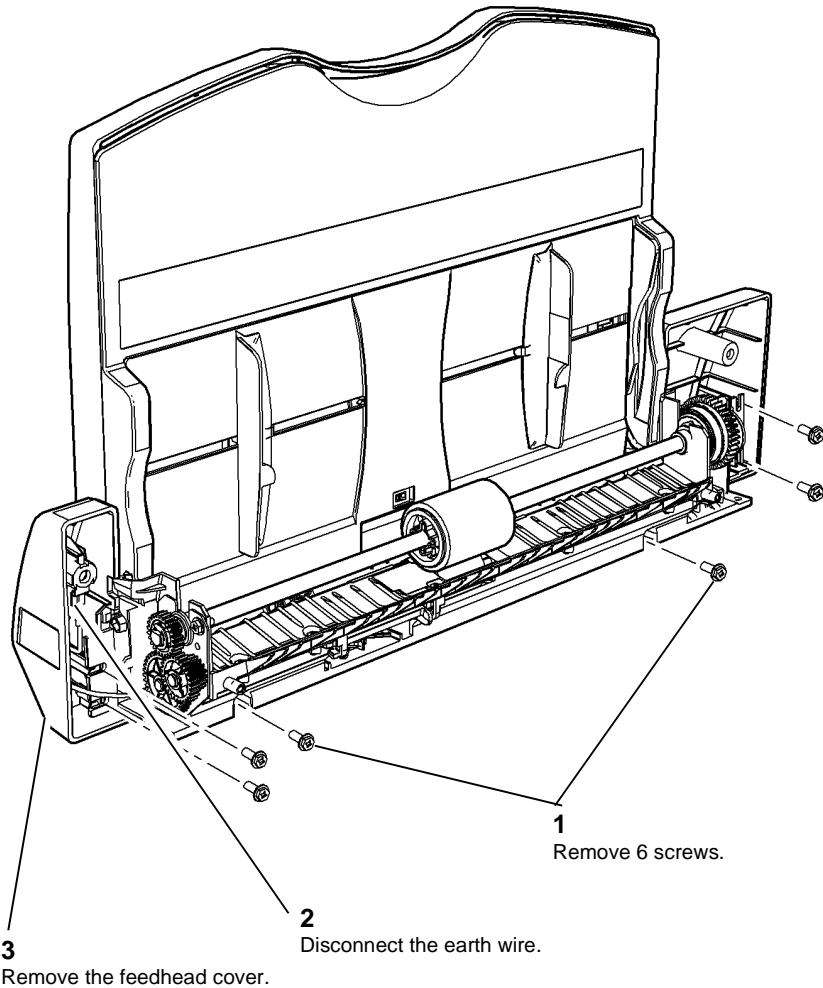
X-1-1417-A

Figure 1 Cover removal

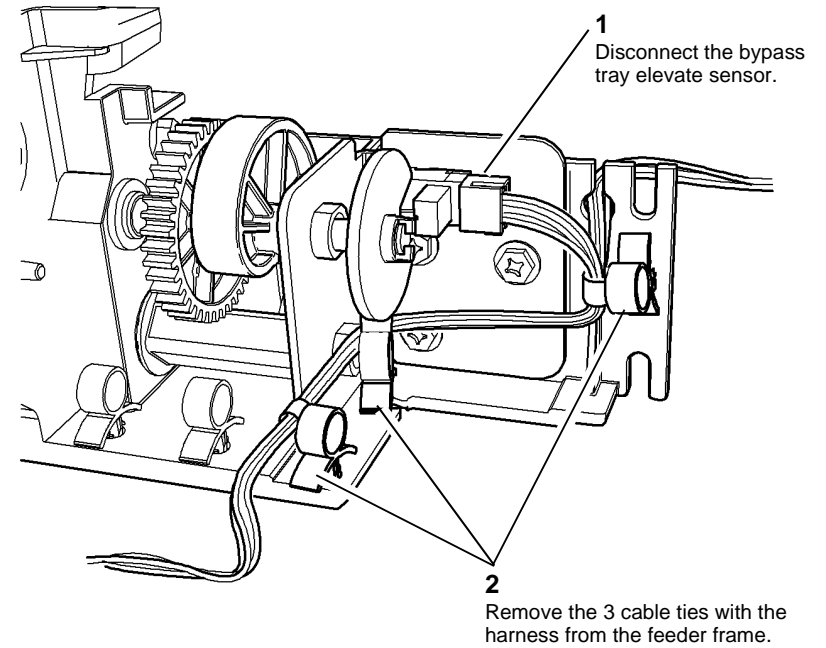
X-1-1420-A

3. Release the bypass tray harness, **Figure 2**.

Figure 2 Sensor and cable ties

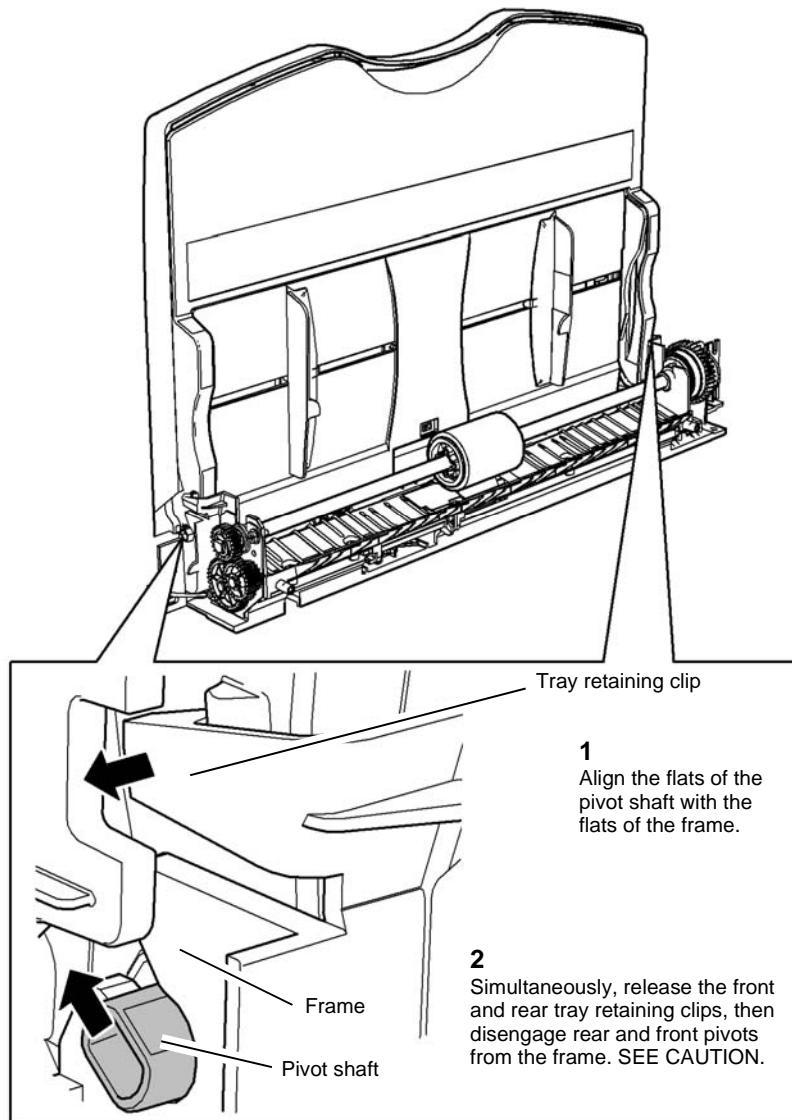
X-1-1428-A

Figure 3 Tray assembly release

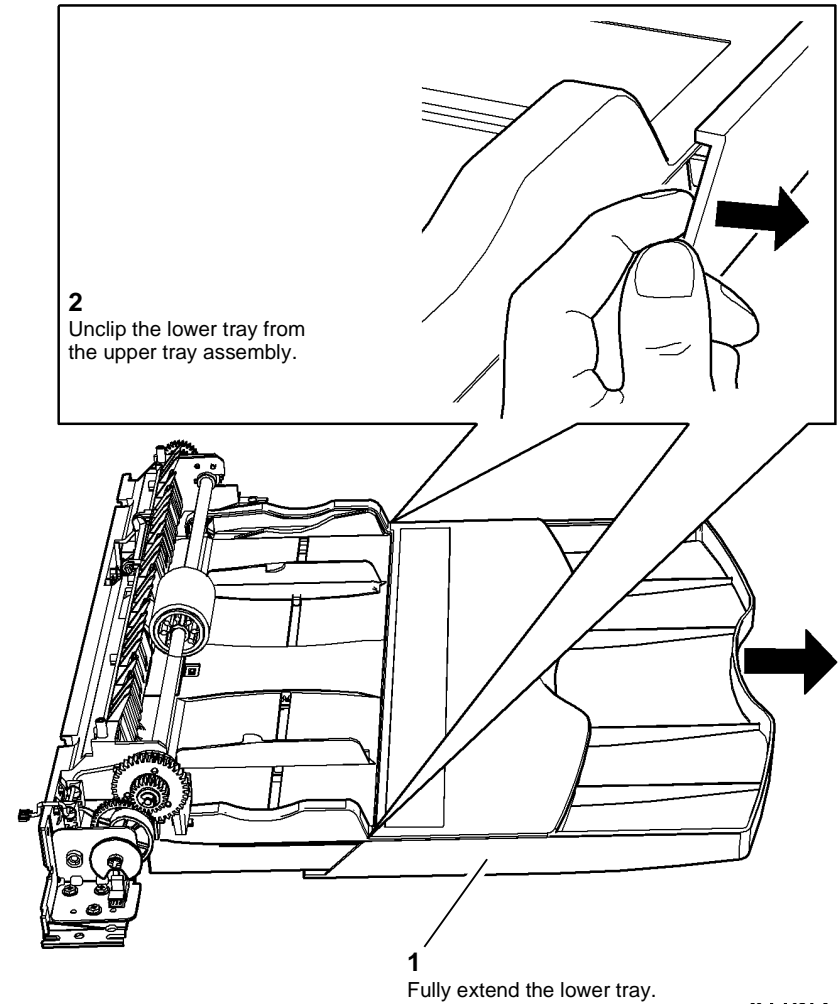
X-1-1421-A

Figure 4 Lower tray removal

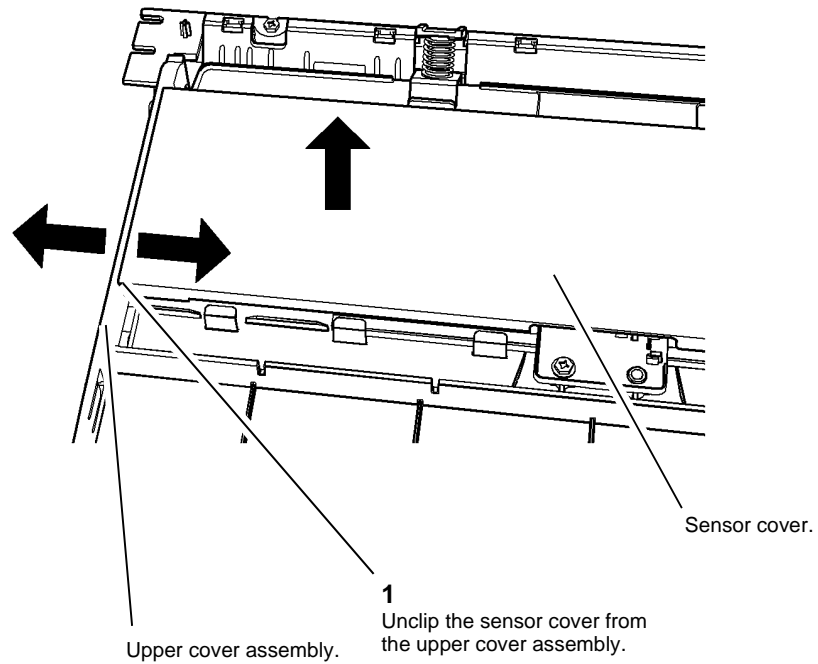
X-1-1422-A

Figure 5 Unclip the sensor cover

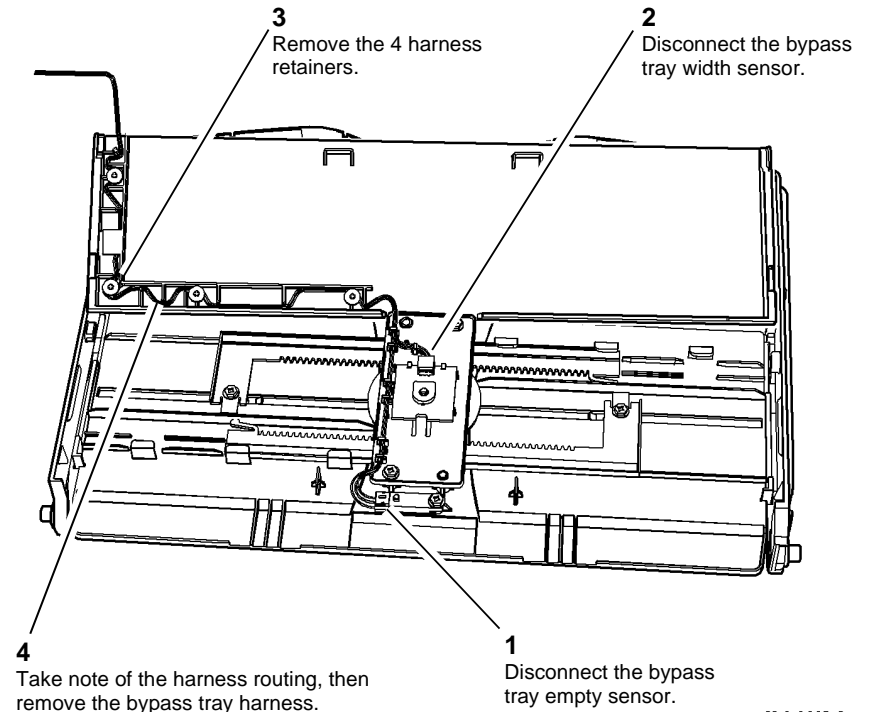
X-1-1419-A

7. Disconnect the sensors and release the bypass tray harness, [Figure 6](#).

Figure 6 Harness routing

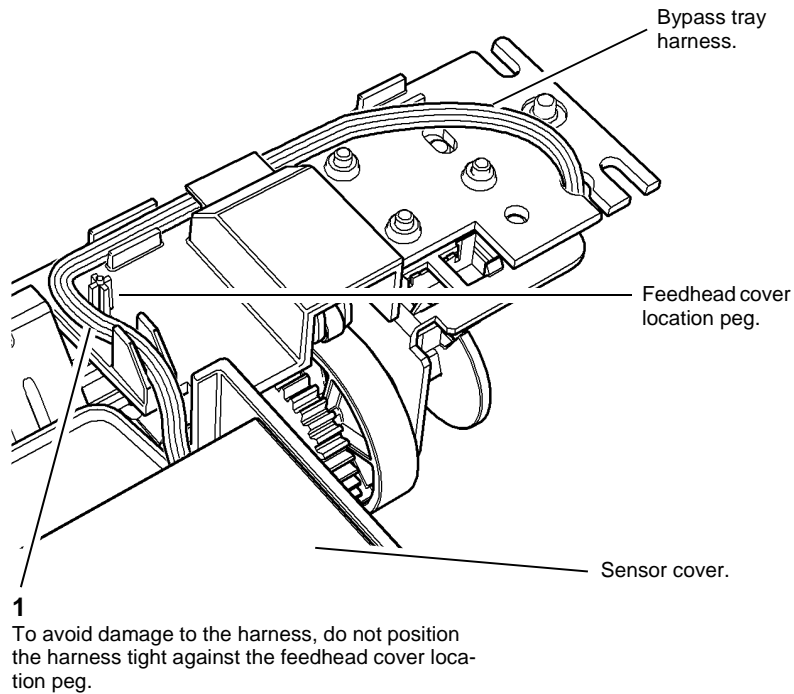
X-1-1418-A

- Ensure the bypass tray harness does not get crushed when the feedhead cover is positioned on the location peg, [Figure 7](#).

Figure 7 Harness routing on the feeder frame

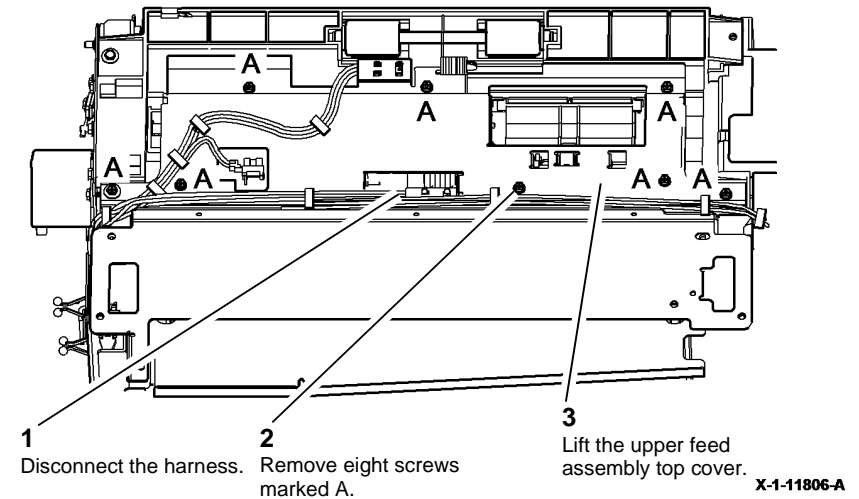
X-1-11806-A

1. Remove the top cover, [REP 70.25](#).
2. Prepare to remove the tray 6 empty sensor, [Figure 1](#).

Figure 1 Preparation

- Check that the harness routing is correct, [Figure 1](#).

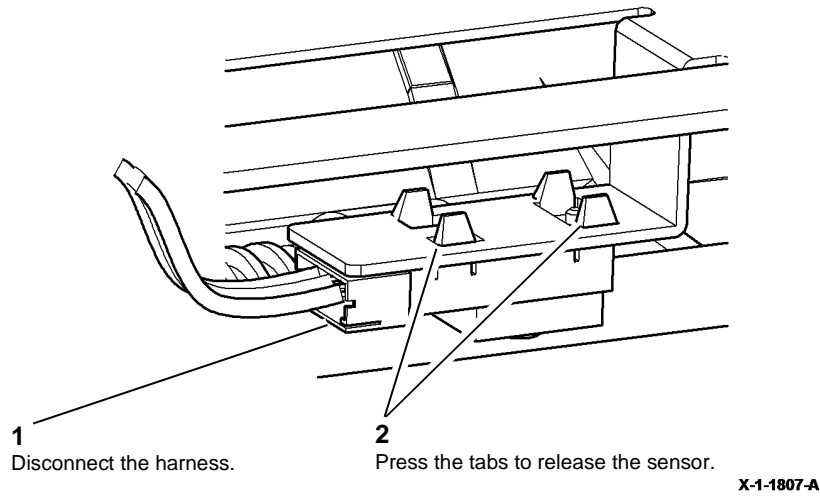
Figure 2 Remove tray 6 empty sensor

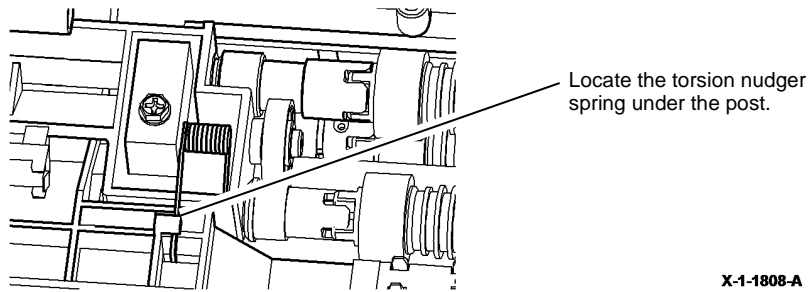
- The replacement is the reverse of the removal procedure.
- Make sure that the torsion nudger spring on the paper feed assembly is in the correct position, [Figure 3](#).

Figure 3 Spring location

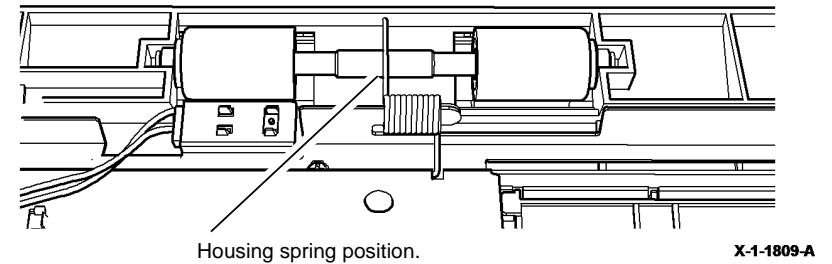
- Make sure that the housing spring is positioned on top of the takeaway idler roller shaft when the upper feed assembly top cover is installed, [Figure 4](#).

Figure 4 Spring position

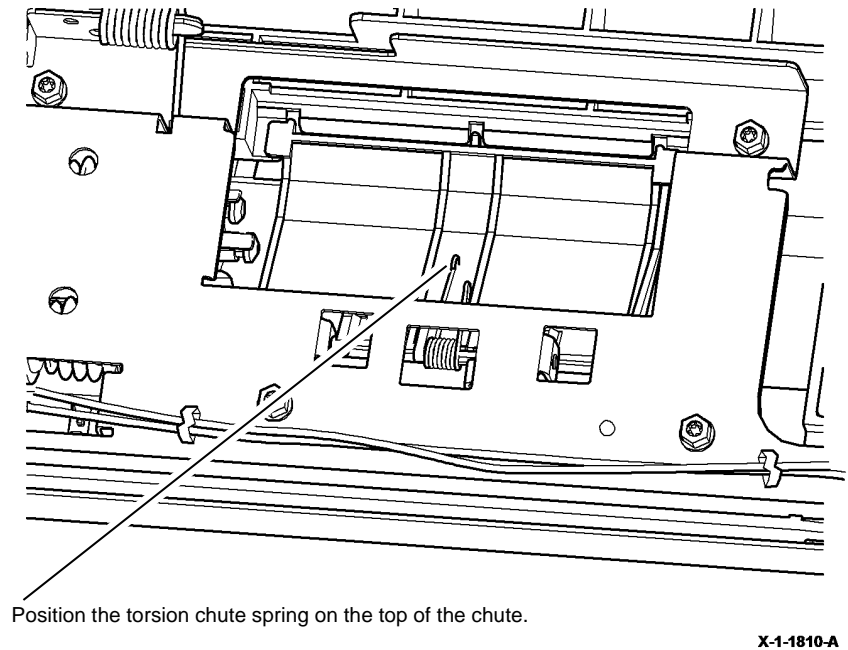
- Check that the correct screw is used to attach the upper feed assembly top cover.
- Make sure that the torsion chute spring is positioned on top of the chute upper insert, [Figure 5](#).

Figure 5 Spring position

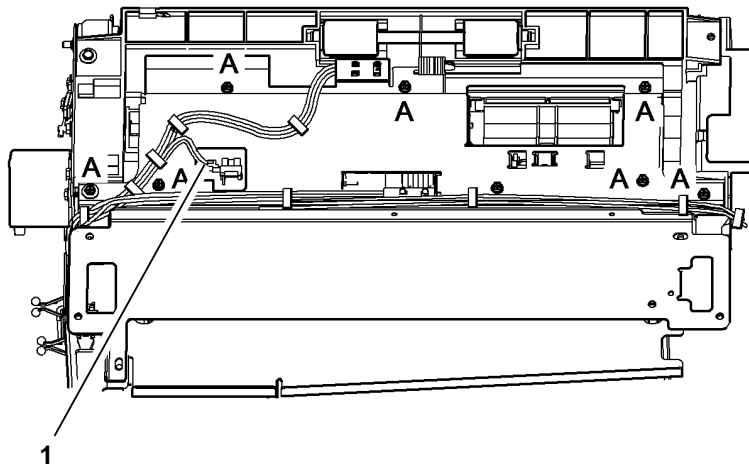
X-1-1811-A

- 1
Disconnect the harness.

Figure 1 Preparation

1. The replacement is the reverse of the removal procedure.
2. Check that the harness routing is correct, [Figure 1](#).

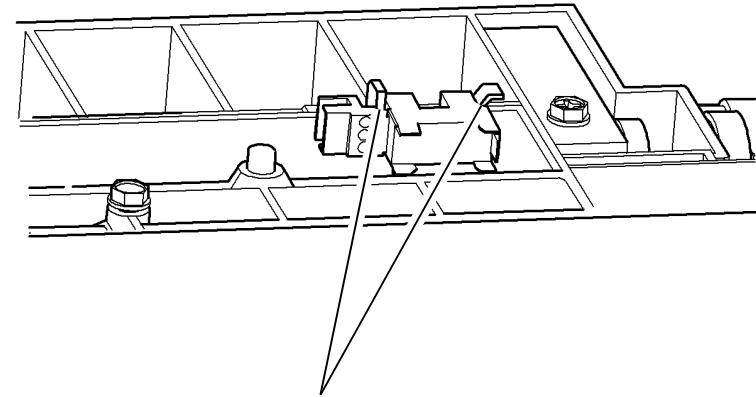
X-1-0812-A

3. Remove tray 6 stack height sensor, [Figure 2](#).

Press the tabs to release the sensor.

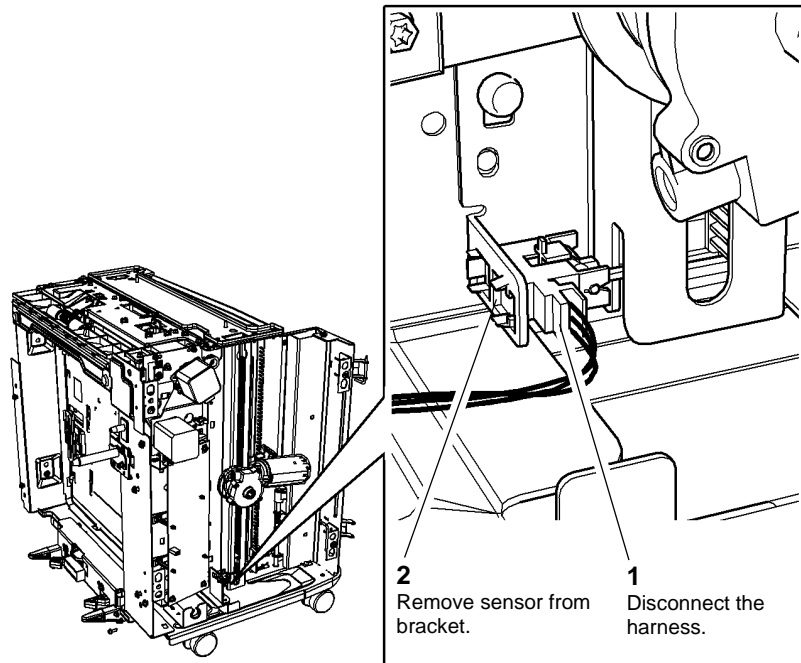
X-1-1813-A

1. Remove the rear cover, [REP 70.25](#).
2. Remove the tray 6 down sensor, [Figure 1](#).

Figure 1 Remove the sensor

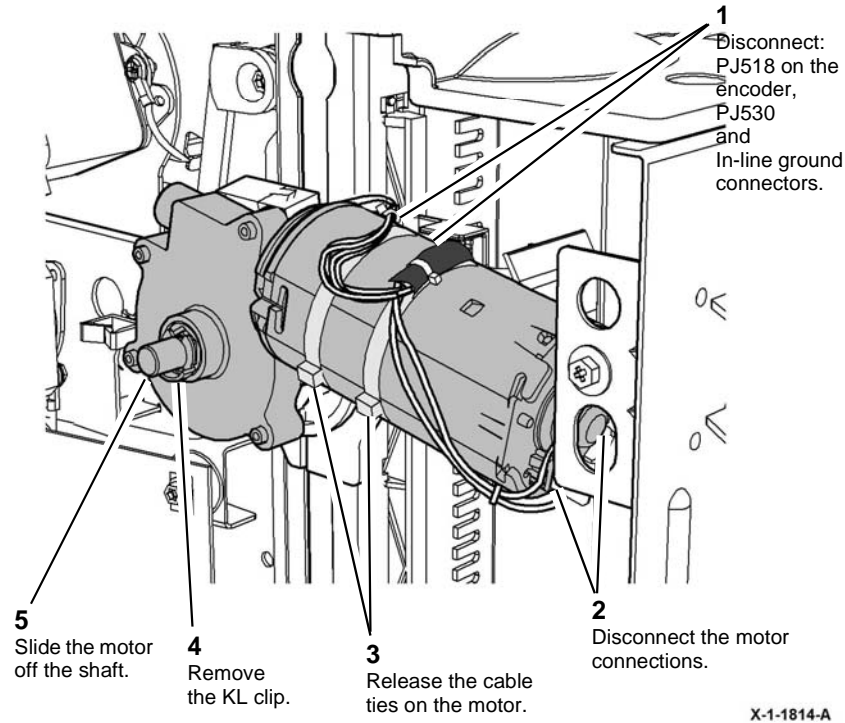
Figure 1 Remove the elevator motor assembly

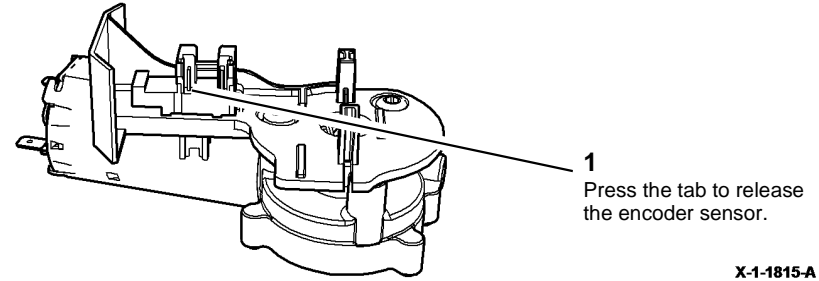
4. If required remove the encoder sensor from the plastic bracket, [Figure 2](#).

Figure 2 Remove the encoder sensor

1. To help with the installing of a new elevator motor, support the paper tray on two reams of paper.
2. Make sure that the encoder sensor is position on the elevator motor assembly, [Figure 2](#).
3. The replacement is the reverse of the removal procedure.
4. Check that the harness is routed in the channel on the plastic bracket, [Figure 3](#).

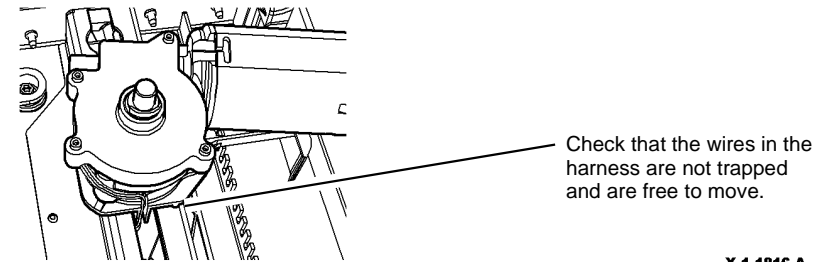
Figure 3 Harness position

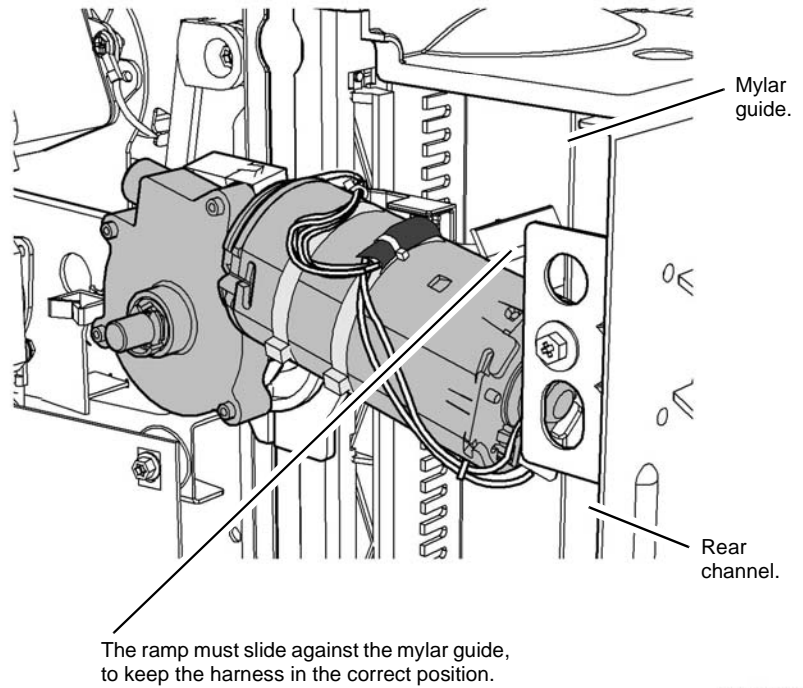
- Exercise the elevator motor with one sheet of paper in the tray. Observe that the harness tracks properly between the mylar guide and the rear channel. [Figure 4](#).

Figure 4 Location of the harness
