708P91368
September 2017

Xerox® AltaLink® B8090 Family Multifunction Printer Service Manual

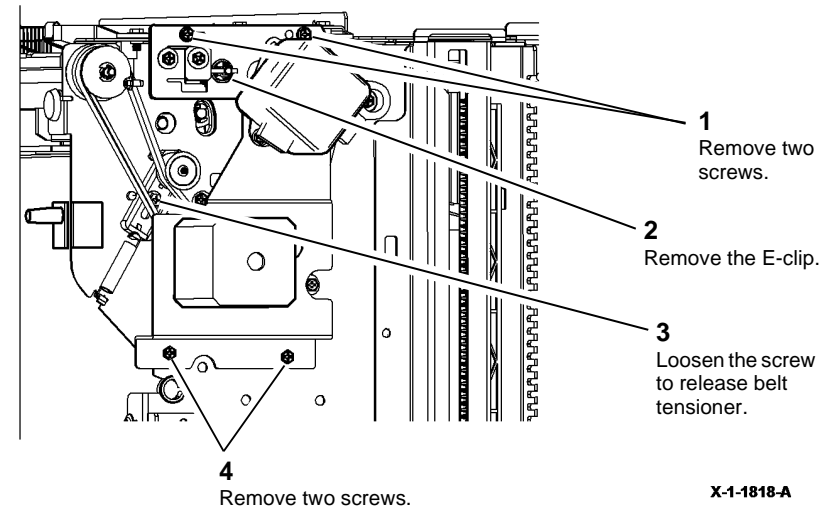
- Remove the rear cover, [REP 70.25](#).
- Remove the top cover, [REP 70.25](#).
- Prepare to remove the tray 6 upper limit switch, [Figure 1](#).

Figure 1 Preparation

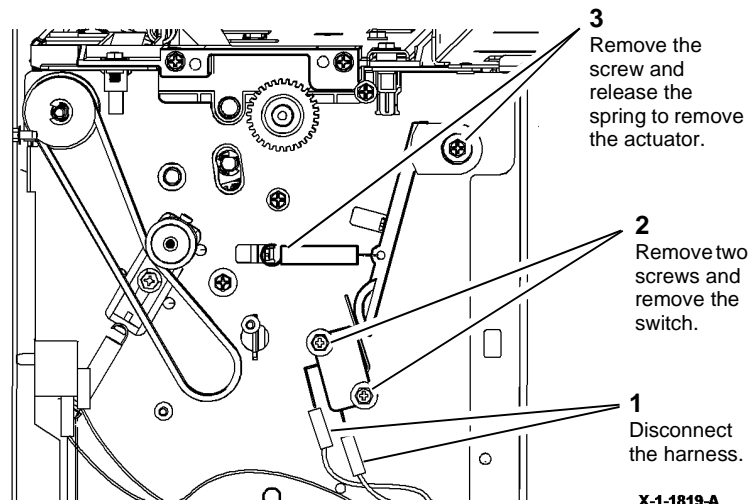
- Remove the tray 6 upper limit switch and the actuator if required, [Figure 2](#).

Figure 2 Remove tray upper limit switch

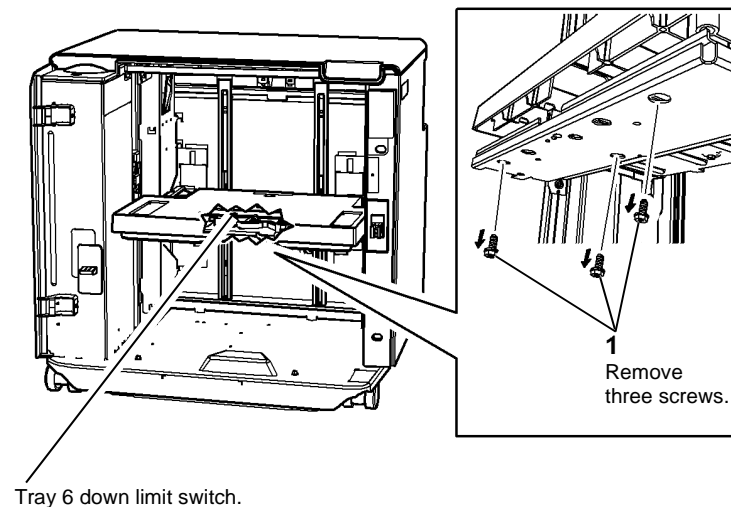
- The tray must be positioned high enough to access the screws shown in [Figure 1](#). If the tray is too low, open the door, remove all but about 1 ream (50mm) of paper, then close the door. When the tray has finished raising, switch off the machine and disconnect the power cord, [GP 14](#).
- Release the paper tray to gain access to the tray 6 down limit switch, [Figure 1](#).

Figure 1 Release the paper tray

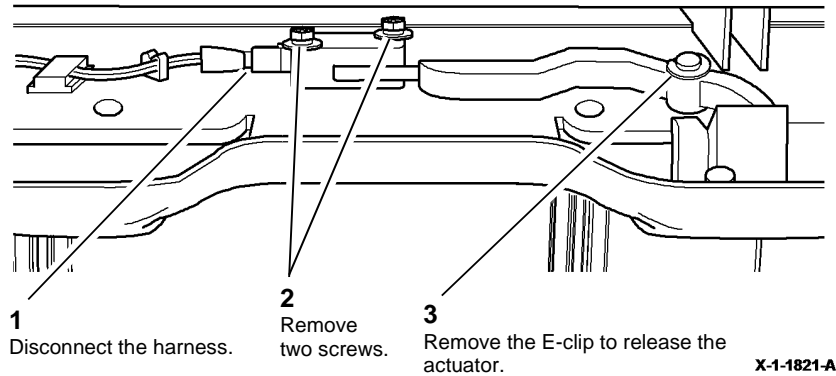
- Lift the tray to access the tray 6 down limit switch and the actuator if required, [Figure 2](#).

Figure 2 Remove tray 6 down limit switch

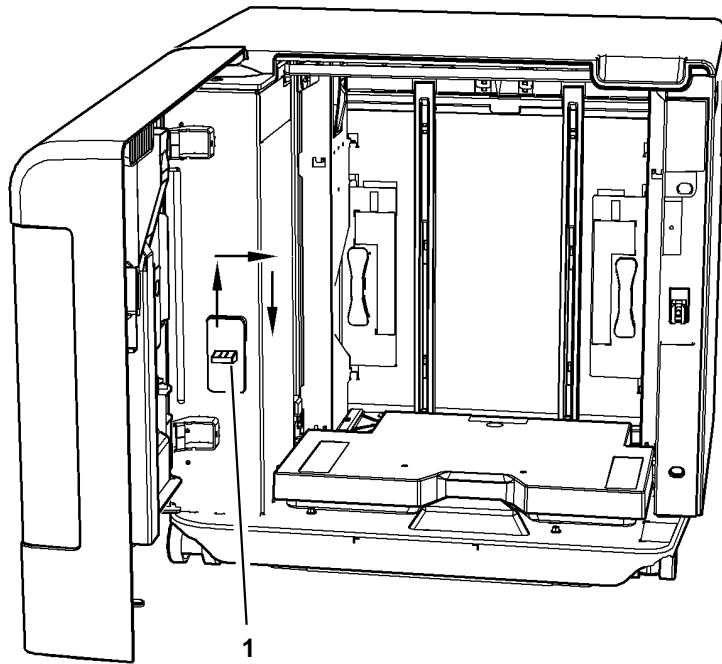
X-1-1822-A

- Engage the transit lock and pull the tray 6 module away from the machine until the lock engages, [Figure 1](#).

1
To engage - lift the lever and move it to the right.

Figure 1 Engage transit lock

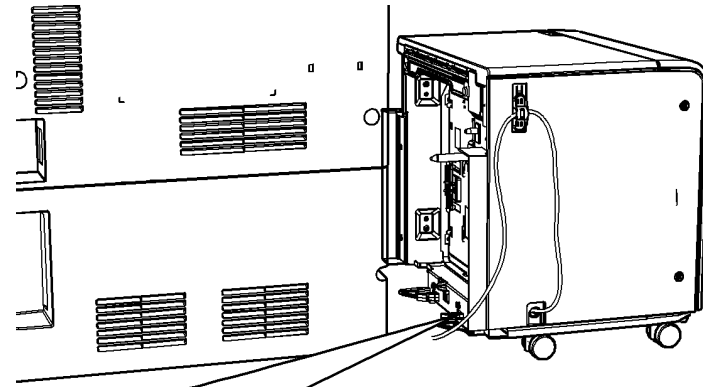
X-1-1823-A

- At the rear of the machine release the latch and pull the tray 6 module away from the machine, [Figure 2](#).

1
Press the lever to release the latch.

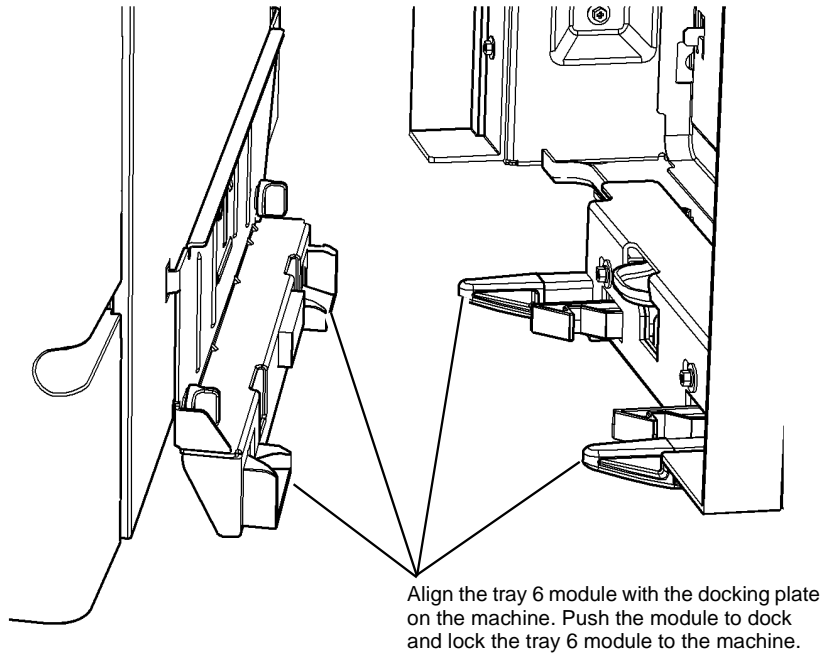
X-1-1824-A

1. The replacement is the reverse of the removal procedure.
2. Position the tray 6 module and align the docking guides with the machine, [Figure 3](#).

Figure 3 Docking the Tray 6 module

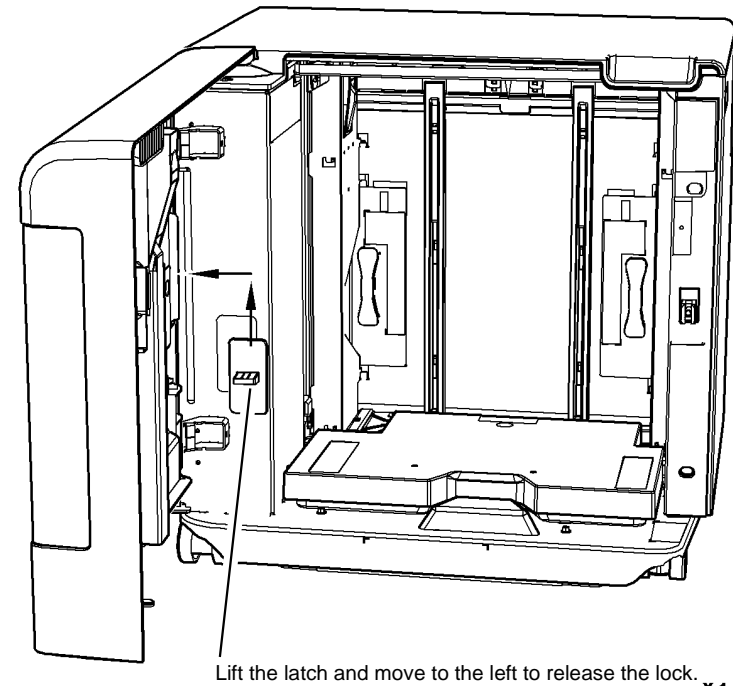
X-1-1825-A

3. Release the transit lock and push the tray 6 module into the docked position against the machine, [Figure 4](#).

Figure 4 Release transit lock

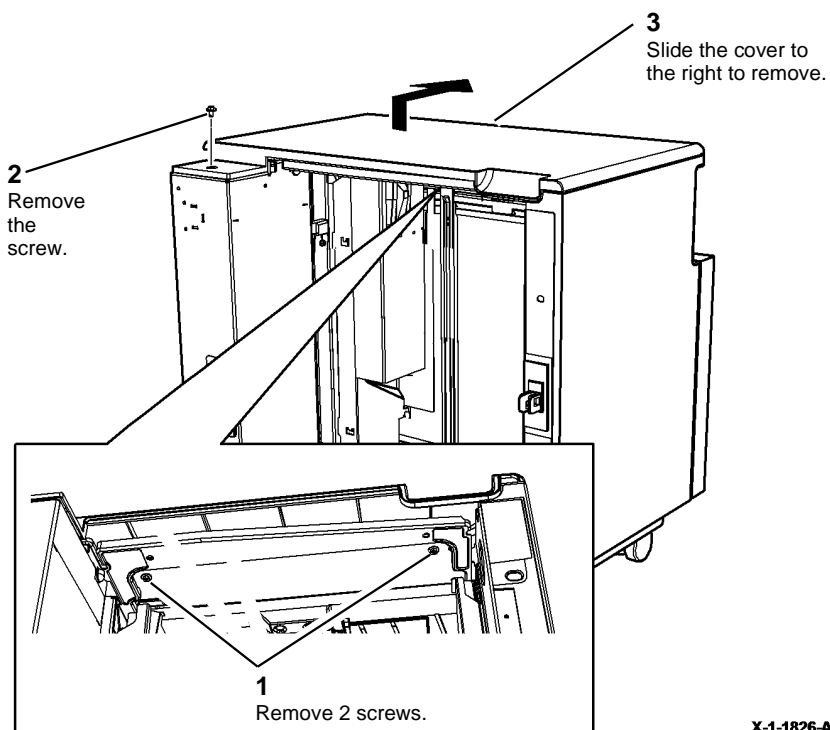
1. Remove the top cover, [Figure 1](#).

Figure 1 Top cover

1. The replacement is the reverse of the removal procedure.
2. Check that the top cover is located correctly, [Figure 1](#).

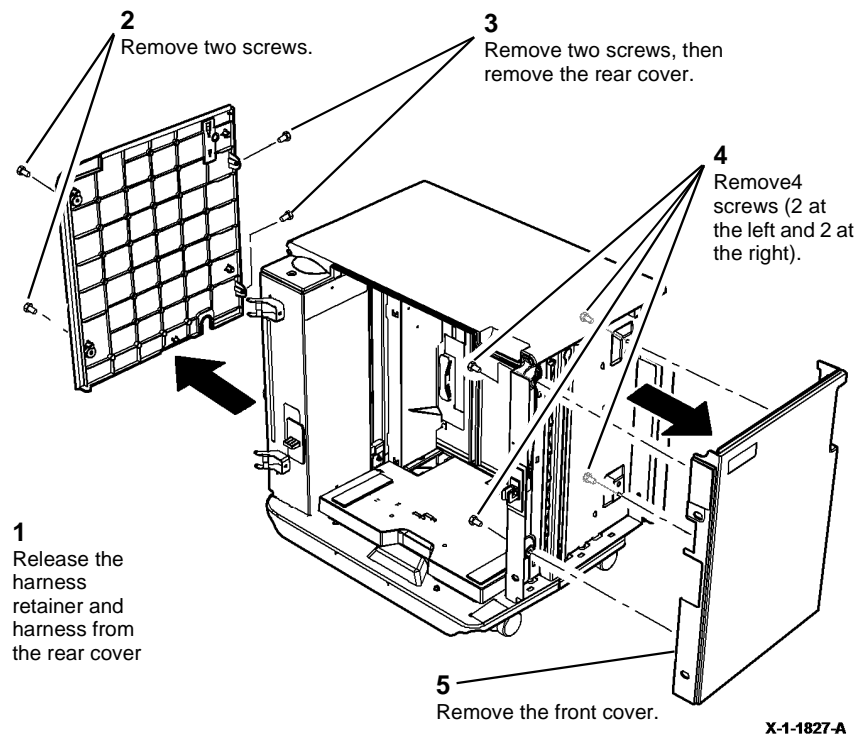
2. Remove the front or rear cover, [Figure 2](#).

Figure 2 Front and rear cover

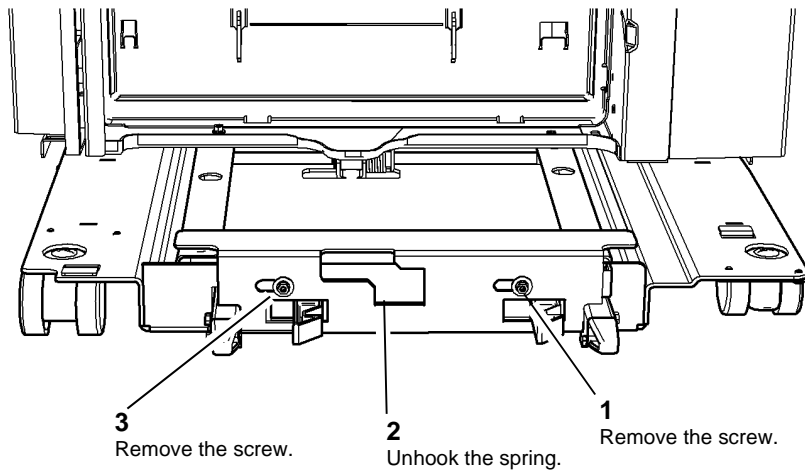
1. Remove the paper and un-dock the tray 6 module, [REP 70.24](#).
2. Prepare to remove the latch assembly, [Figure 1](#).

3 Remove the screw.

2 Unhook the spring.

Figure 1 Preparation

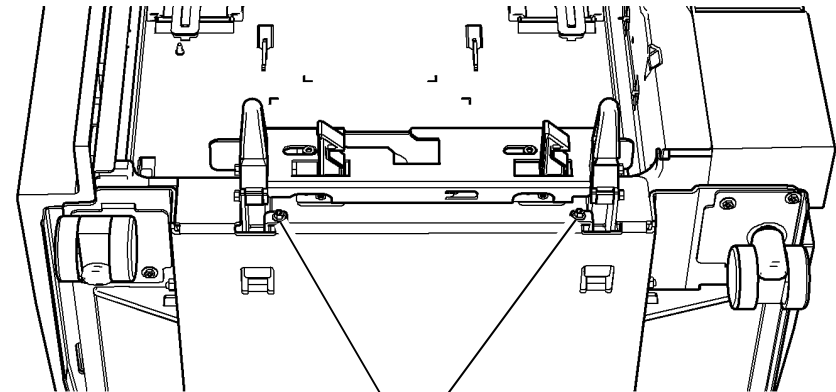
X-1-1829-A

3. Turn tray 6 onto its end to access the fixing screws on the docking latch main bracket. If tray 6 has a 11x17 / A3 or 8.5 x 11 / 14 kit then turn the tray 6 on it's side. [Figure 2](#).

Remove 2 screws.

Figure 2 Remove the latch assembly

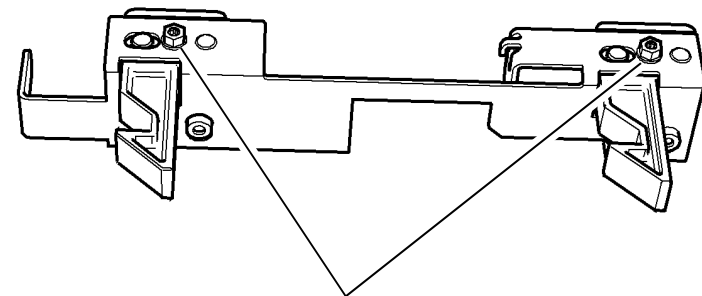
X-1-1830-A

4. Note the orientation of the latches and then remove the docking latches, [Figure 3](#).

Remove the fixing screw, then remove the docking latch.

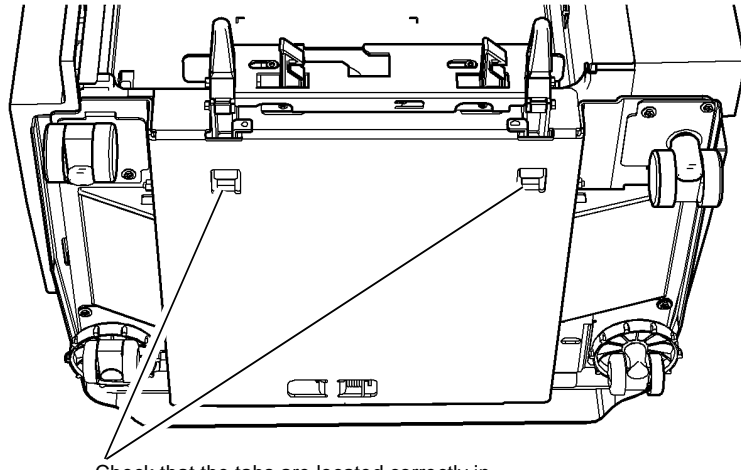
X-1-1831-A

1. The replacement is the reverse of the removal procedure.
2. Check that the tabs are located correctly on the base plate when refitting the latch assembly, [Figure 4](#).

Check that the tabs are located correctly in the base.

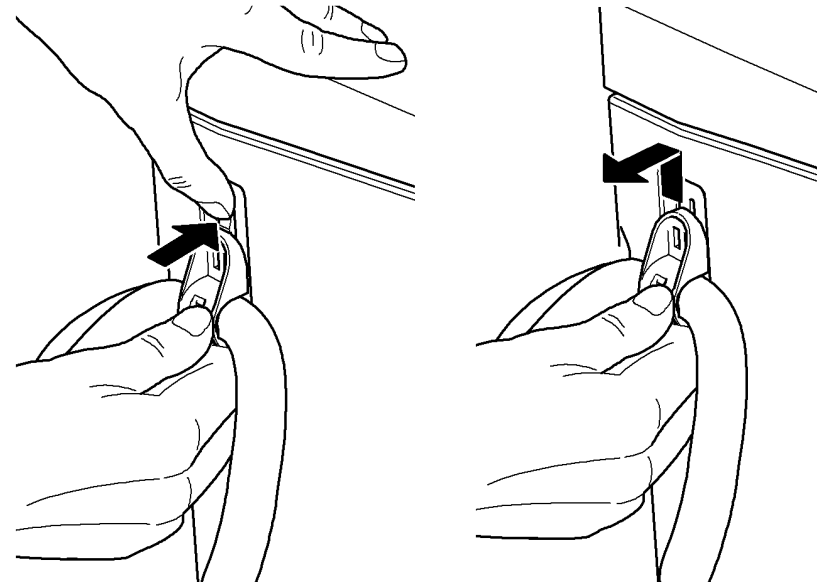
1. Release the cable clamp from the rear cover, [Figure 1](#).

1
Press the locking clip towards the module.

2
Slide the cable clamp off the module, in an upwards direction.

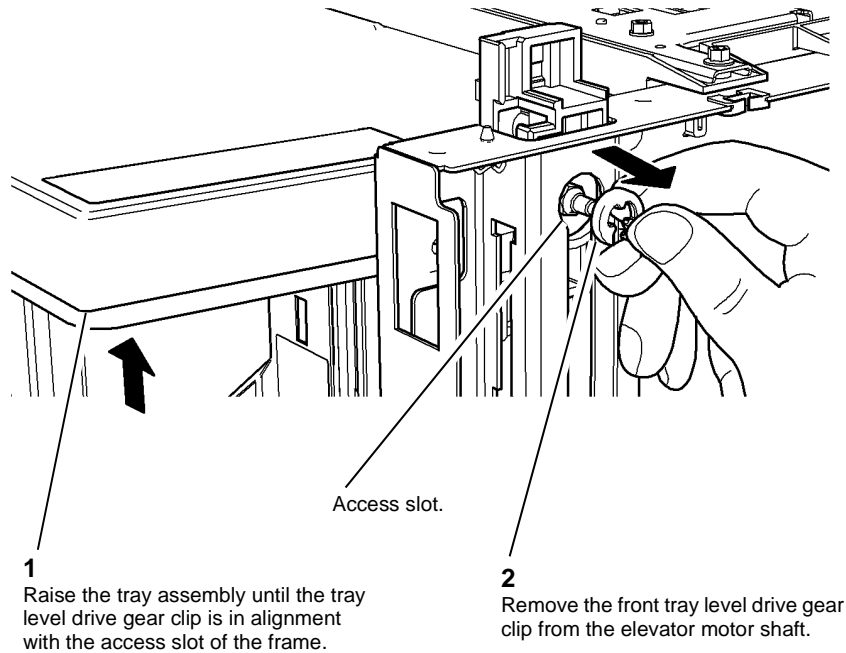
X-1-1833-A

4. Remove the top, front and rear covers, [REP 70.25](#).
5. Remove the elevator motor assembly, [REP 70.21](#).
6. Remove the frame top brace, [PL 75.68 Item 3](#).
7. Remove the crash bar, [PL 75.68 Item 2](#).
8. Remove the upper feeder assembly, [REP 80.42](#).
9. Prepare to remove the tray assembly, [Figure 2](#) and [Figure 3](#).

Figure 2 Tray assembly front view

4. Insert the front and rear the rear tray level drive gear clip, [Figure 2](#), [Figure 3](#).
5. The remainder of replacement is the reverse of the removal procedure.

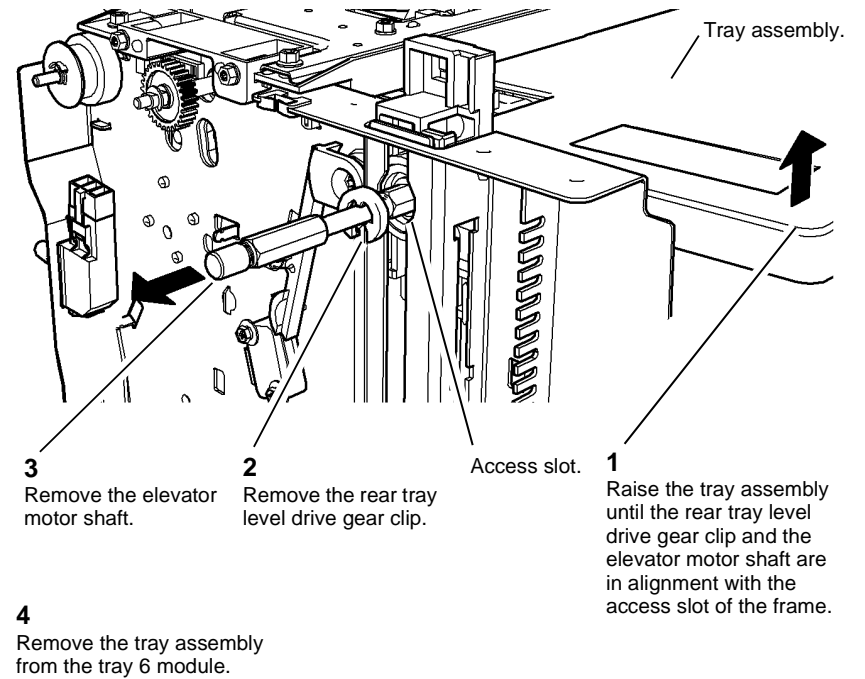
X-1-1834-A

Figure 3 Tray assembly rear view

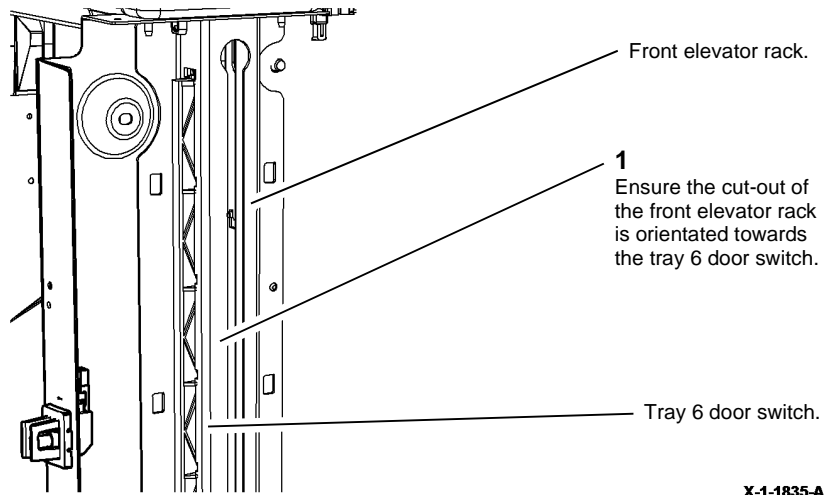
NOTE: Only the front elevator rack has a clearance cut-out to accommodate the tray 6 door switch, [Figure 4](#).

Figure 4 Front elevator rack

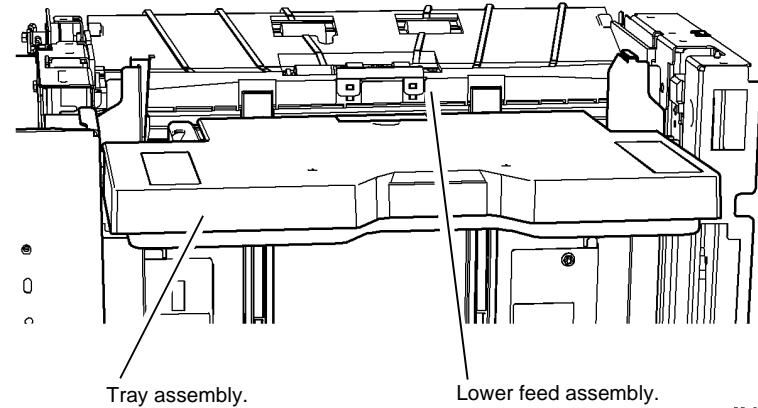
1. Install the elevator motor shaft into the tray assembly.
2. Place the tray assembly in the top of the module and insert the front and rear drive gears.
3. Ensure that the tray assembly is in horizontal alignment with the lower feeder assembly, [Figure 5](#). If necessary raise the tray assembly until the drive gears are just above the racks, align the tray again and then lower onto the racks.

Figure 5 Tray alignment

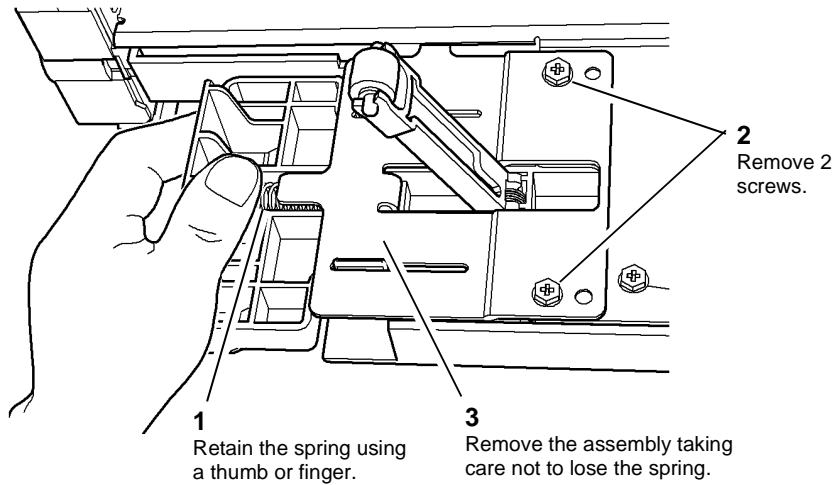
1. Remove the tray assembly from the tray 6 module, by performing [REP 70.27](#) steps 1 to 11.
2. Remove the front and rear drive gears, [PL 75.68](#) Item 28.
3. Remove the elevator motor shaft, [PL 75.68](#) Item 7.
4. Remove the infill plate assembly, [Figure 1](#).

Figure 1 Infill plate assembly removal

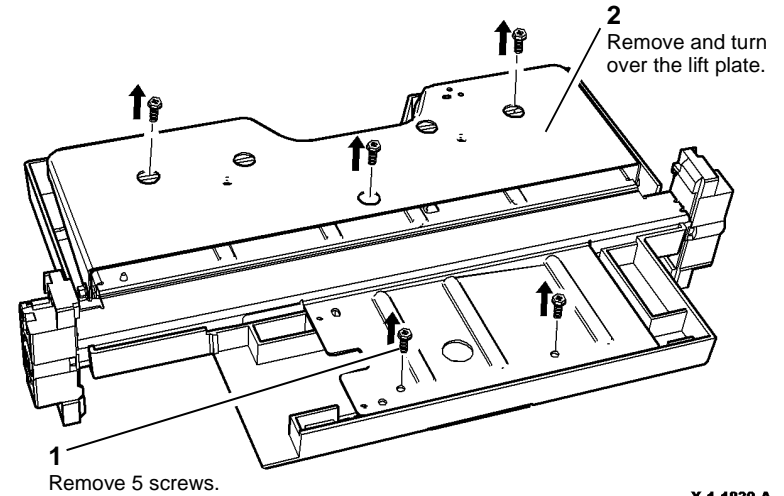
5. Separate the lift plate from the tray lift top cover, [Figure 2](#).

Figure 2 Tray separation

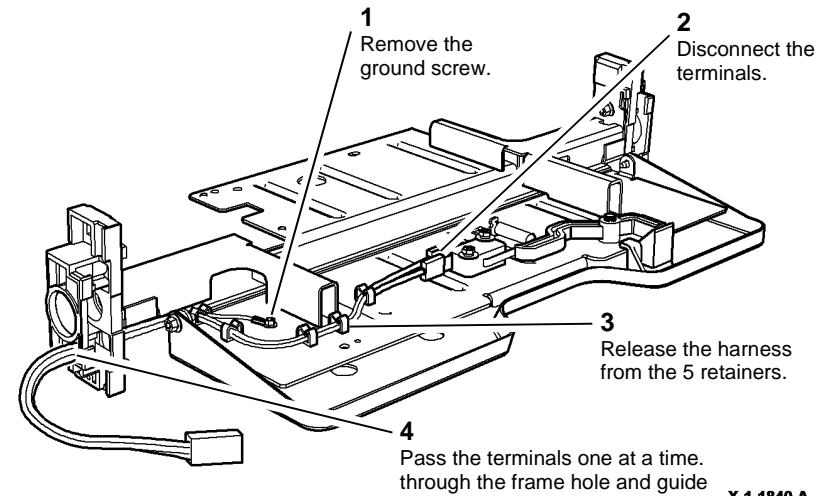
6. Remove the tray 6 elevator harness, [Figure 3](#).

Figure 3 Harness removal

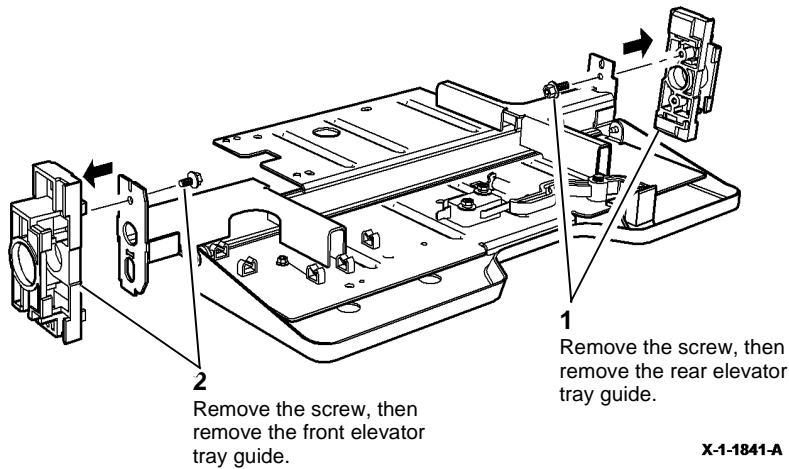
- Remove the elevator tray guides, [Figure 4](#).

Figure 4 Elevator tray guides removal

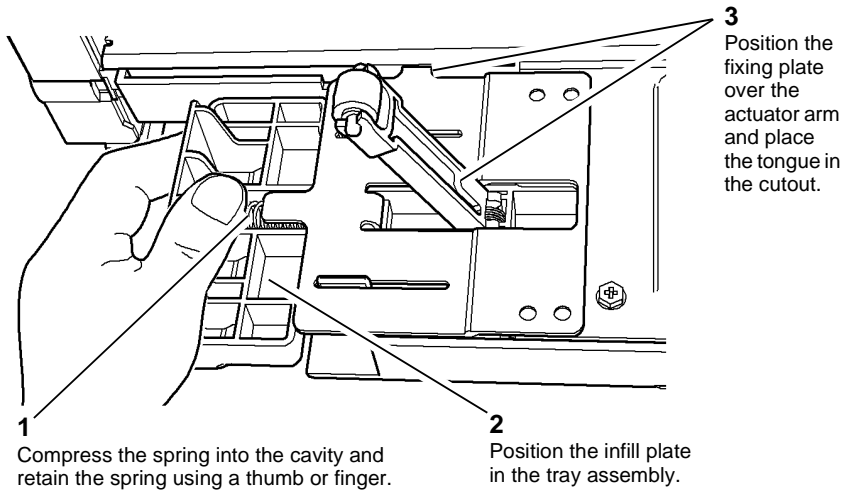
- Re-assemble the elevator tray by reversing the removal steps 3 to 5.
- Install the rear guide assembly, [Figure 5](#) and [Figure 6](#).

Figure 5 Rear guide assembly install

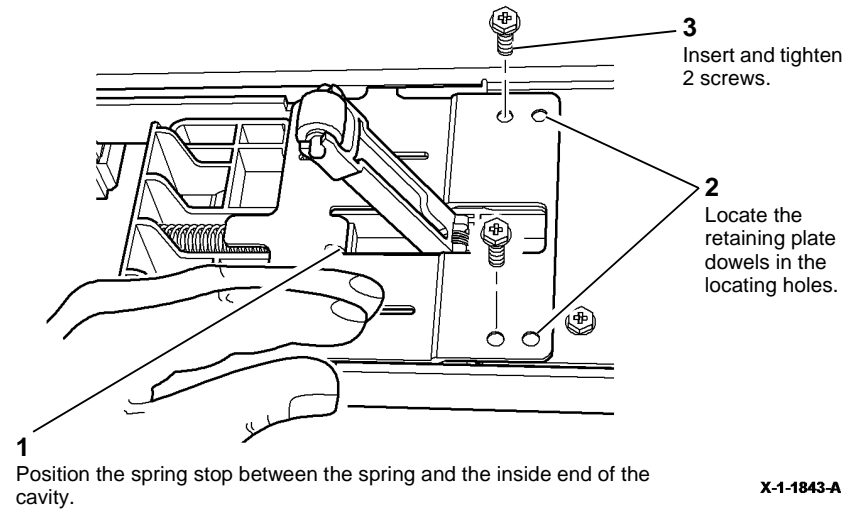
Figure 6 Rear guide assembly install

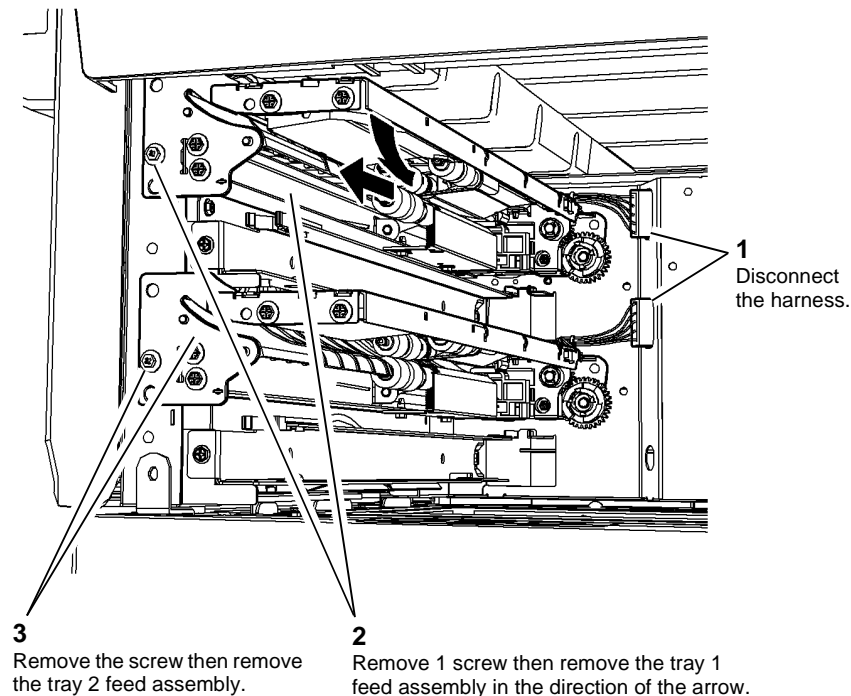
1. Remove tray 1 or tray 2 as required, [REP 70.1](#).
2. Remove the tray 1 or tray 2 feed assembly, [Figure 1](#).

Figure 1 Paper feed assembly removal

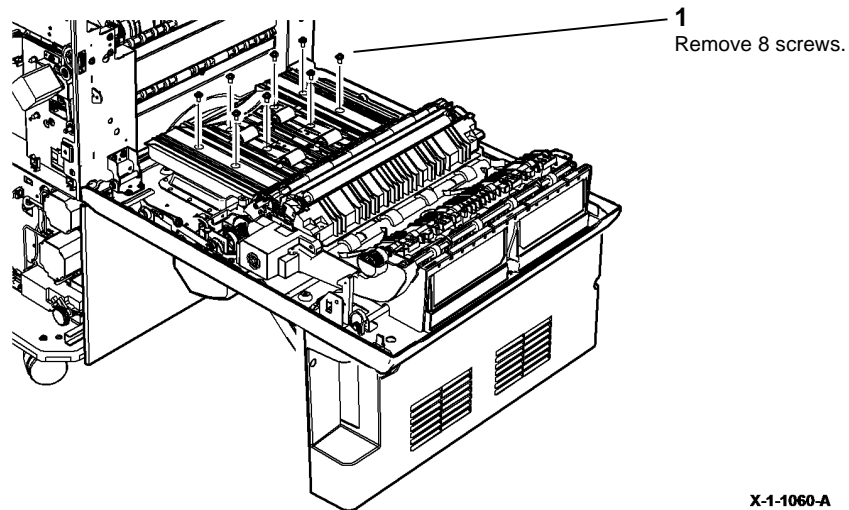
X-1-1060-A

1. Open the left door into the service position, [GP 37](#).
2. Prepare to remove the lower left door paper guide, [Figure 1](#).

Figure 1 Preparation

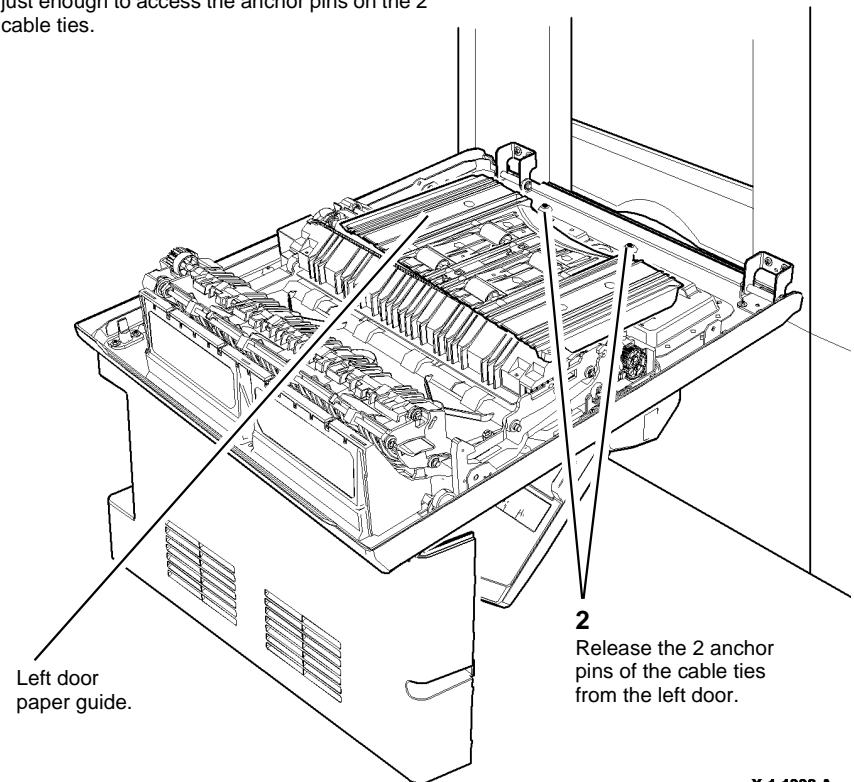
X-1-1338-A

3. Release the TAR 1 and TAR 2 sensor harness cable ties (2 places) [Figure 2](#).

1
Avoid strain on the TAR 1 and TAR 2 sensor harness. Bias the lower left door paper guide just enough to access the anchor pins on the 2 cable ties.

Figure 2 TAR 1 and TAR 2 sensor harness fixings

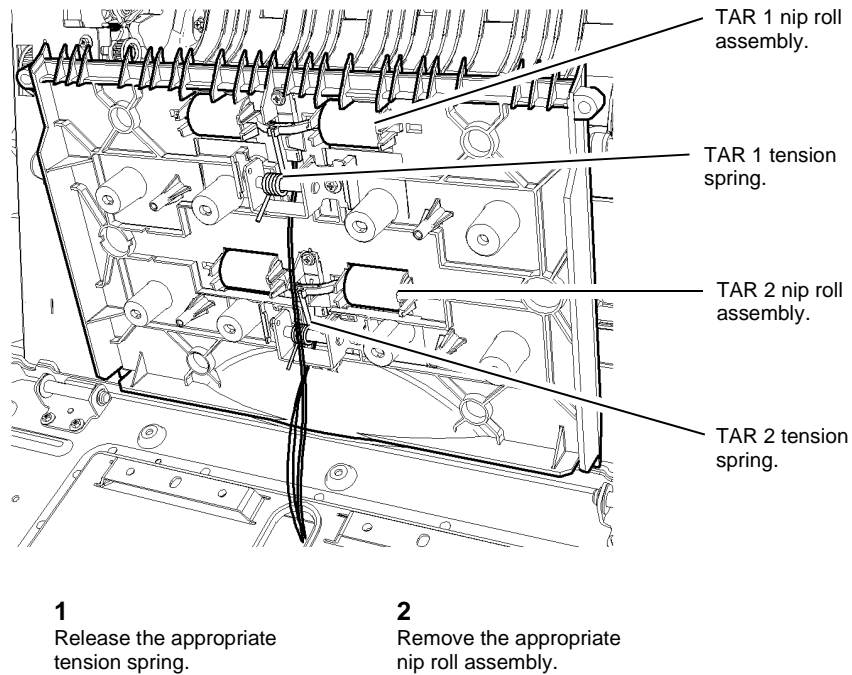
X-1-1339-A

4. Prepare to disconnect the TAR 1 or TAR 2 sensors, [Figure 3](#).

Figure 3 Lower left door nip rolls

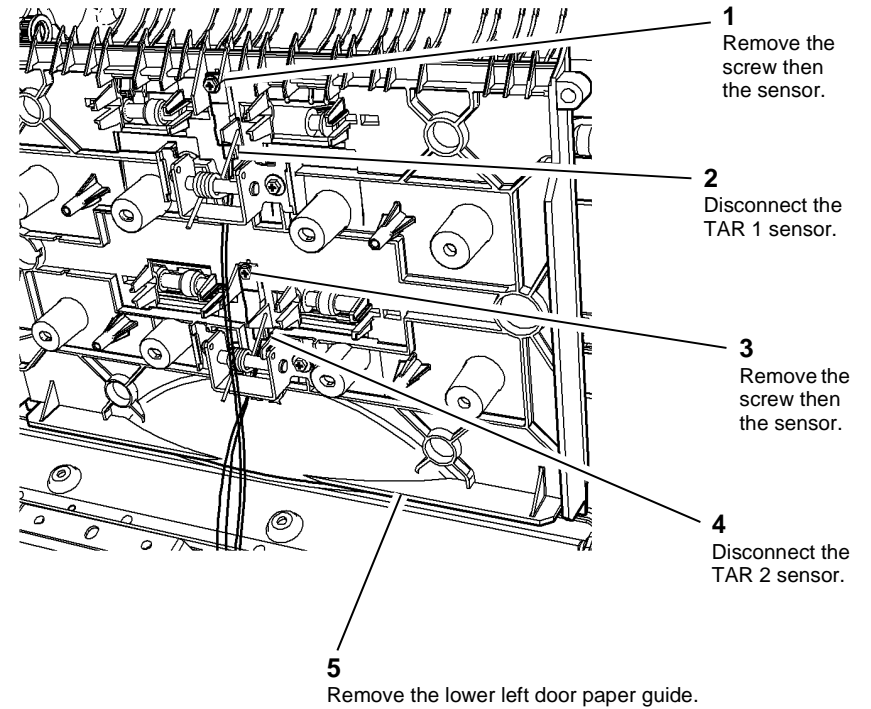
X-1-1061-A

5. Remove the lower left door paper guide, [Figure 4](#).

Figure 4 Sensor and guide removal

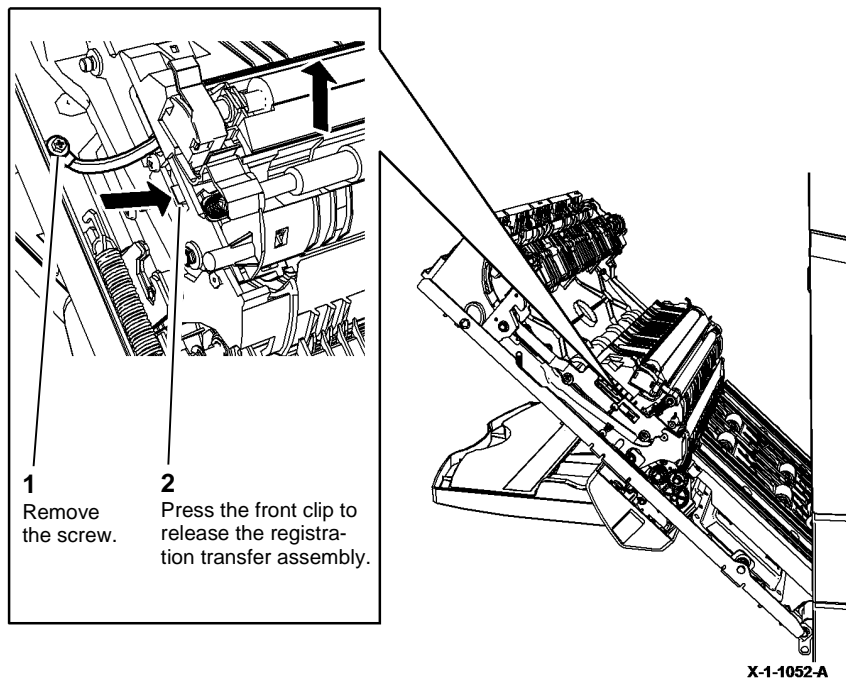
1. Open the left door, [PL 80.10 Item 1](#).
2. Remove the print cartridge, [PL 90.17 Item 9](#), then place in a black bag.
3. Remove the registration transfer assembly, [Figure 1](#).

Figure 1 Registration transfer assembly removal

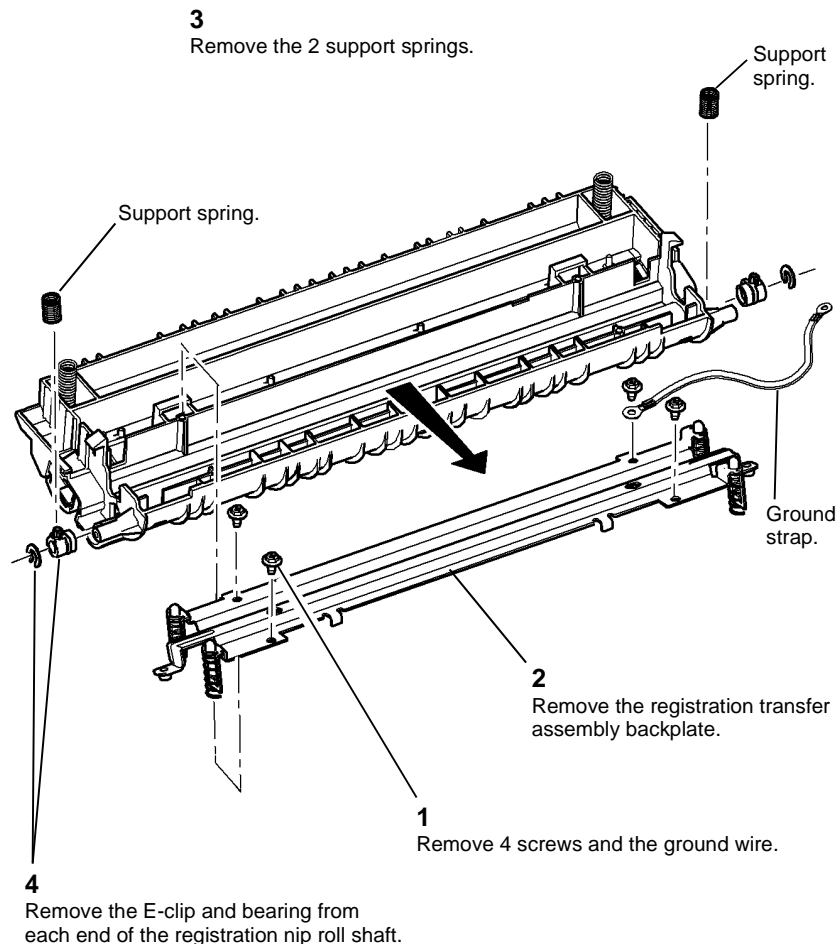
4. Prepare to remove the registration nip roll, [Figure 2](#).

Figure 2 Registration backplate assembly

1. Replacement is the reverse of the removal procedure. Refer to [GP 6](#) before refitting the screws.
2. Ensure the ground strap is installed, [Figure 2](#).
3. Perform the [dC604](#) Registration Setup procedure.
4. Check the registration transfer assembly for ground continuity and electrical resistance, perform the [301A](#) Ground Distribution RAP - [Registration Transfer Ground](#).

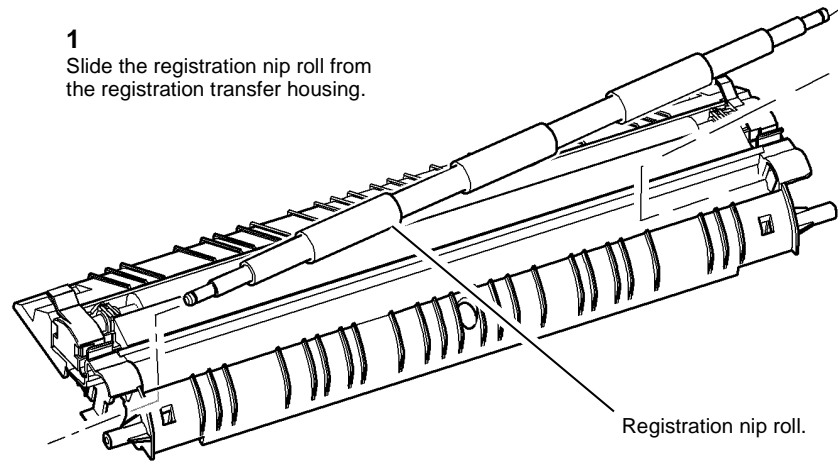
X-1-1054-A

5. Remove the registration nip roll, [Figure 3](#).

Figure 3 Registration nip roll removal

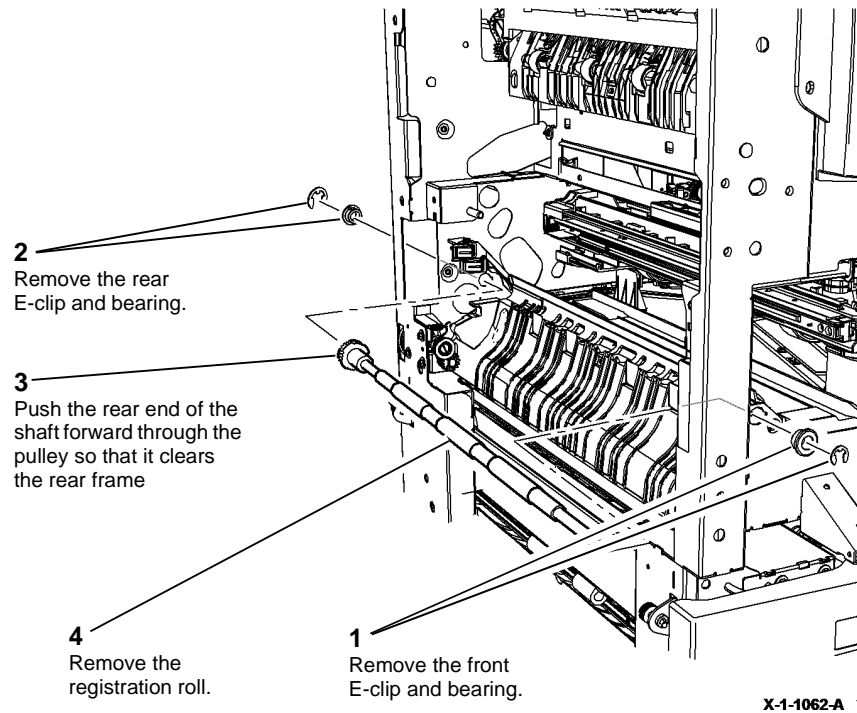
X-1-1062-A

7. Remove the registration roll, [Figure 1](#).

Figure 1 Registration roll removal

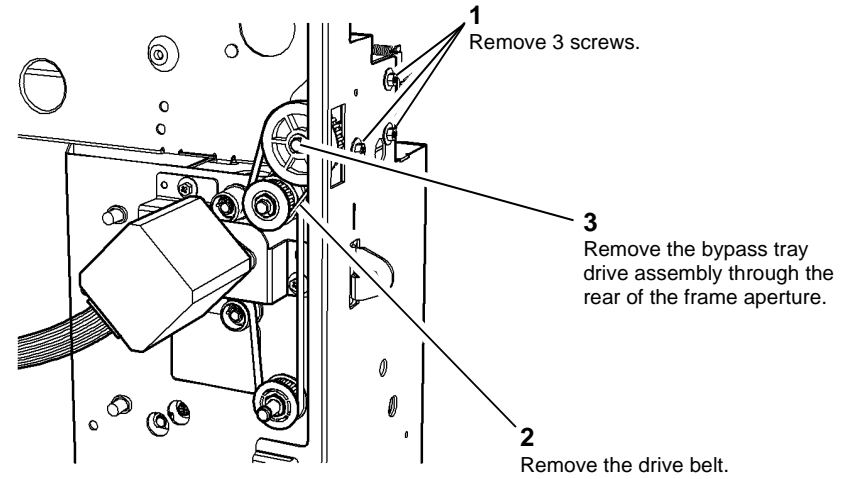
X-1-1063-A

8. Remove the bypass tray drive assembly, [Figure 2](#).

Figure 2 Bypass tray drive assembly removal

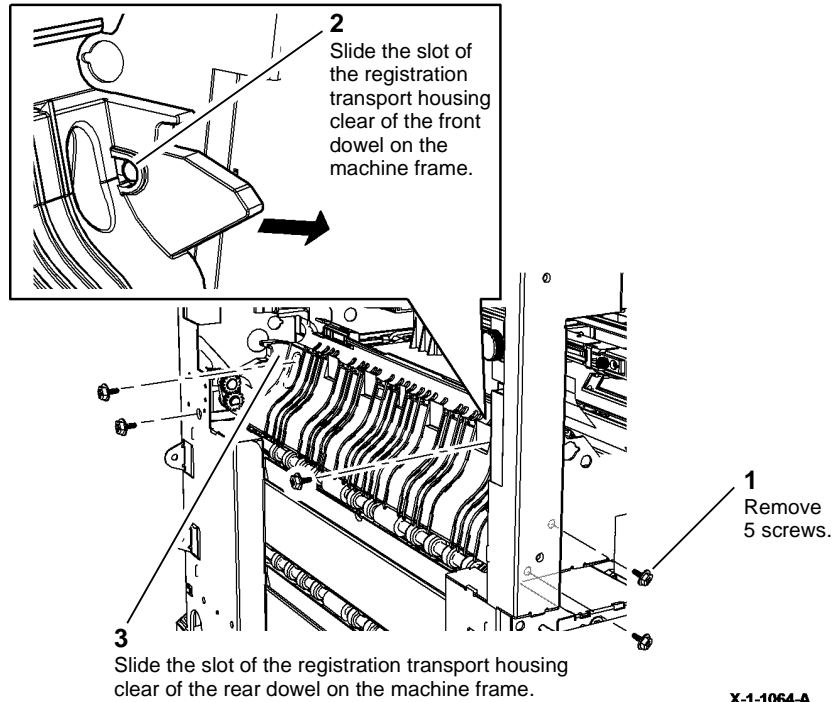
Figure 3 Preparation

9. Prepare to remove the registration transport housing, [Figure 3](#).

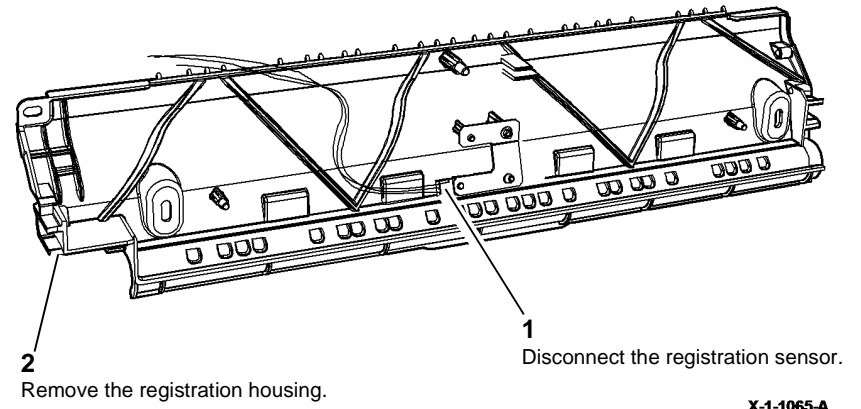
Figure 4 Housing removal

10. Remove the registration transport housing, [Figure 4](#).

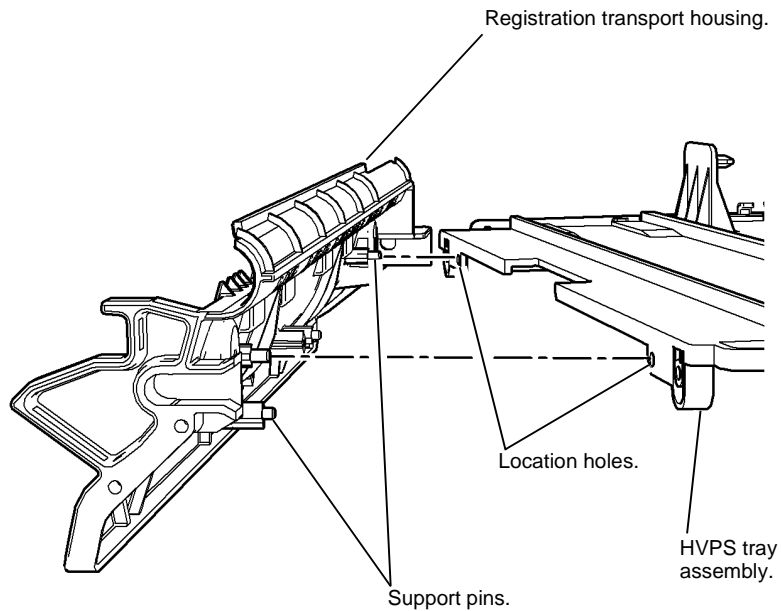
Figure 5 Housing replacement

1. Replacement is the reverse of the removal procedure. Refer to GP 6 before refitting the screws
2. Ensure the 2 support pins on the registration transport housing engage into the 2 location holes of the HVPS tray assembly, Figure 5.

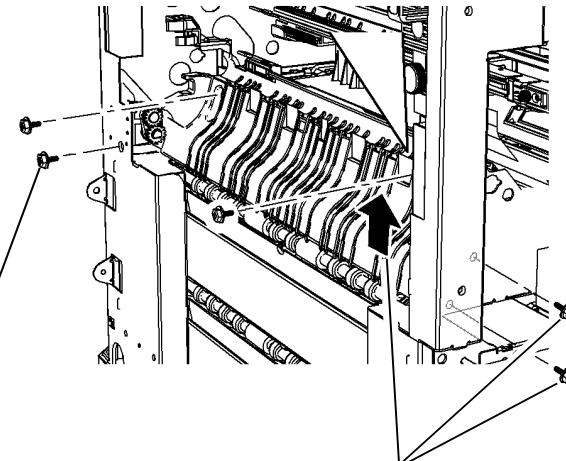
Ensure the front of the registration transport housing is biased fully up before tightening the screws.

3. Secure the registration transport housing, Figure 6.

1
Loosely install the 5 screws.

3
Tighten the remaining 3 screws.

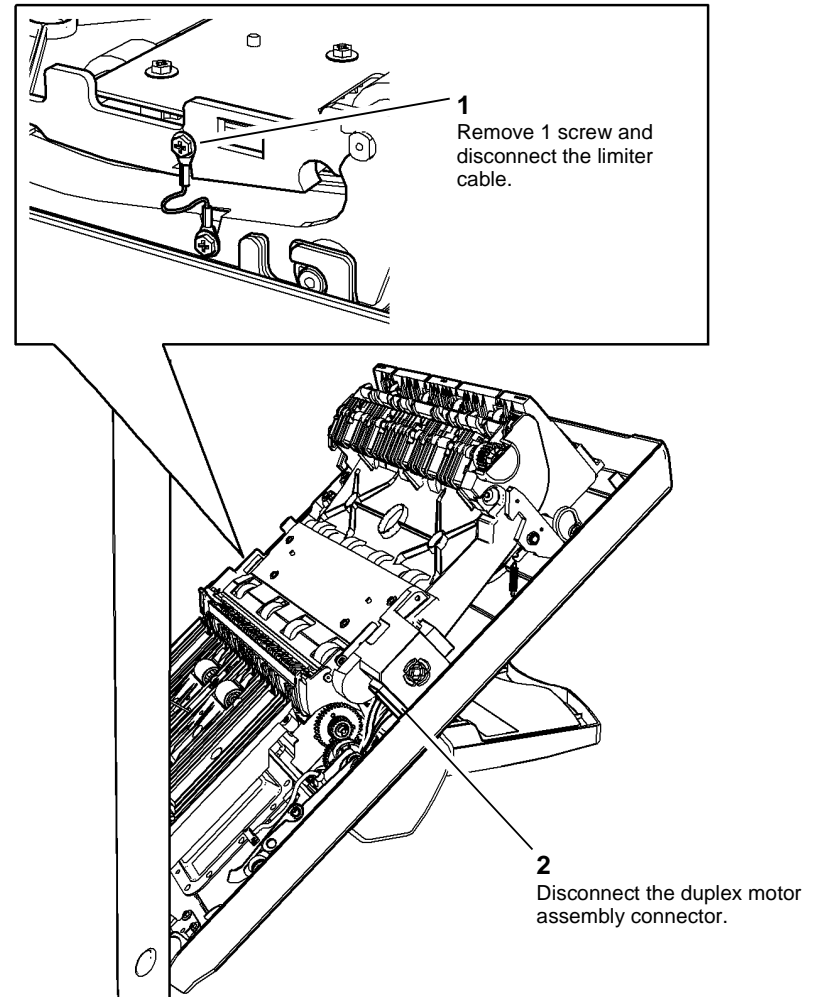
Figure 1 Preparation

1. Open the left door, [PL 80.10 Item 1](#).
2. Remove the print cartridge, [PL 90.17 Item 9](#), then place in a black bag.
3. Remove the registration transfer assembly, [REP 80.3](#).
4. Prepare to remove the duplex transport assembly, [Figure 1](#).

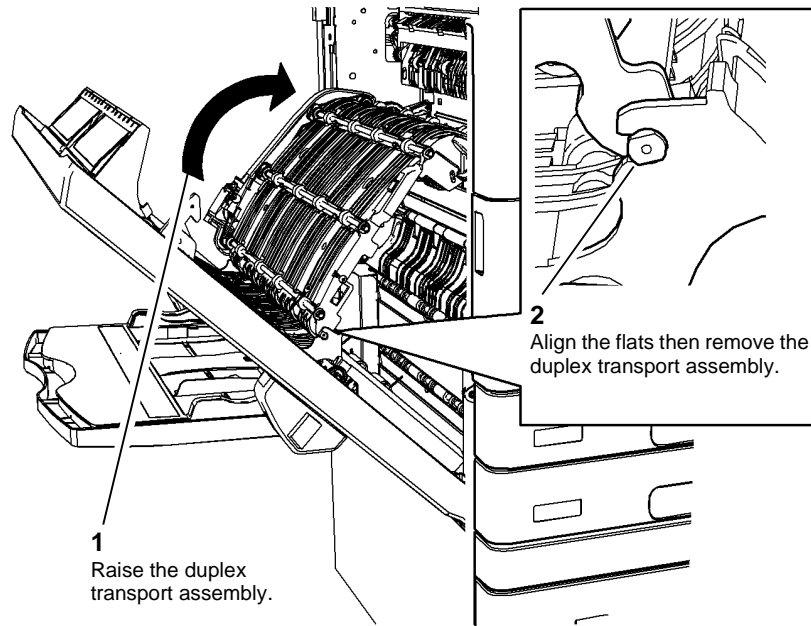
Figure 2 Removal

6. Remove the duplex transport assembly, [Figure 2](#).

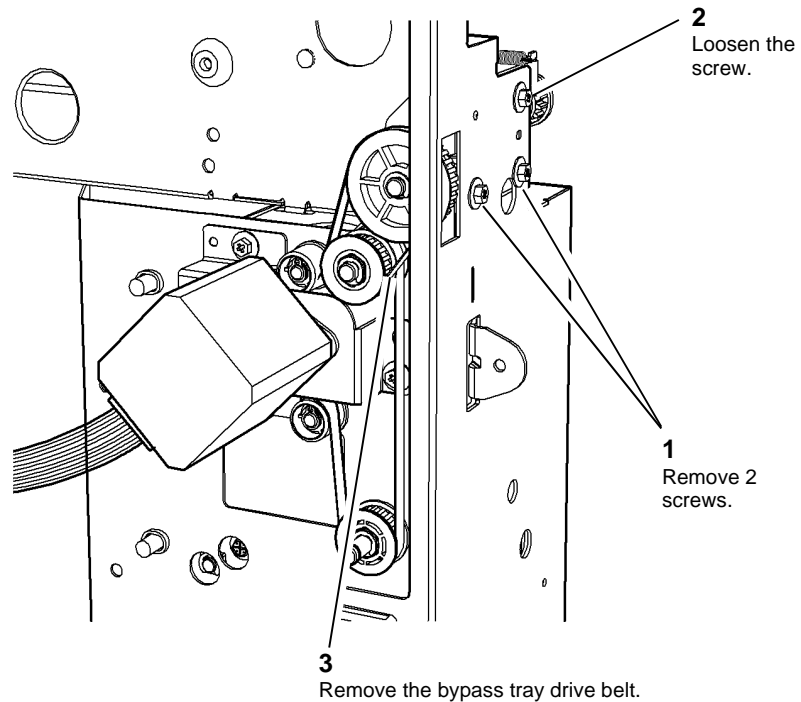
Figure 1 Drive Belt Removal

4. Remove the bypass tray drive belt, [Figure 1](#).

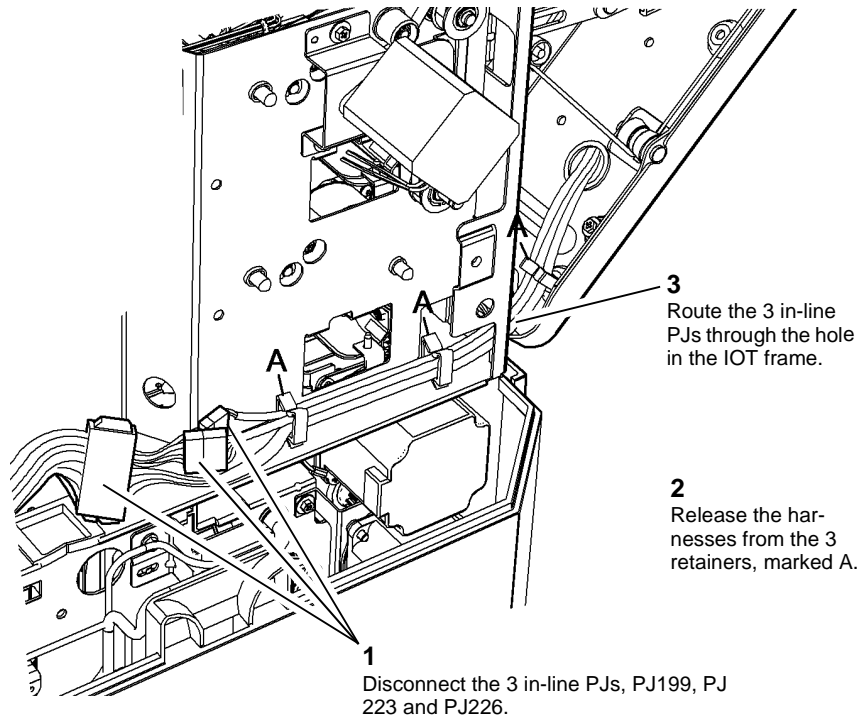
Figure 1 Left door harness connections

4. Disconnect the harnesses between the IOT and the left door assembly, [Figure 1](#).

NOTE: Partial opening of tray 2 will allow greater clearance for the routing of the harnesses.
