708P91368
September 2017

Xerox® AltaLink® B8090 Family Multifunction Printer Service Manual

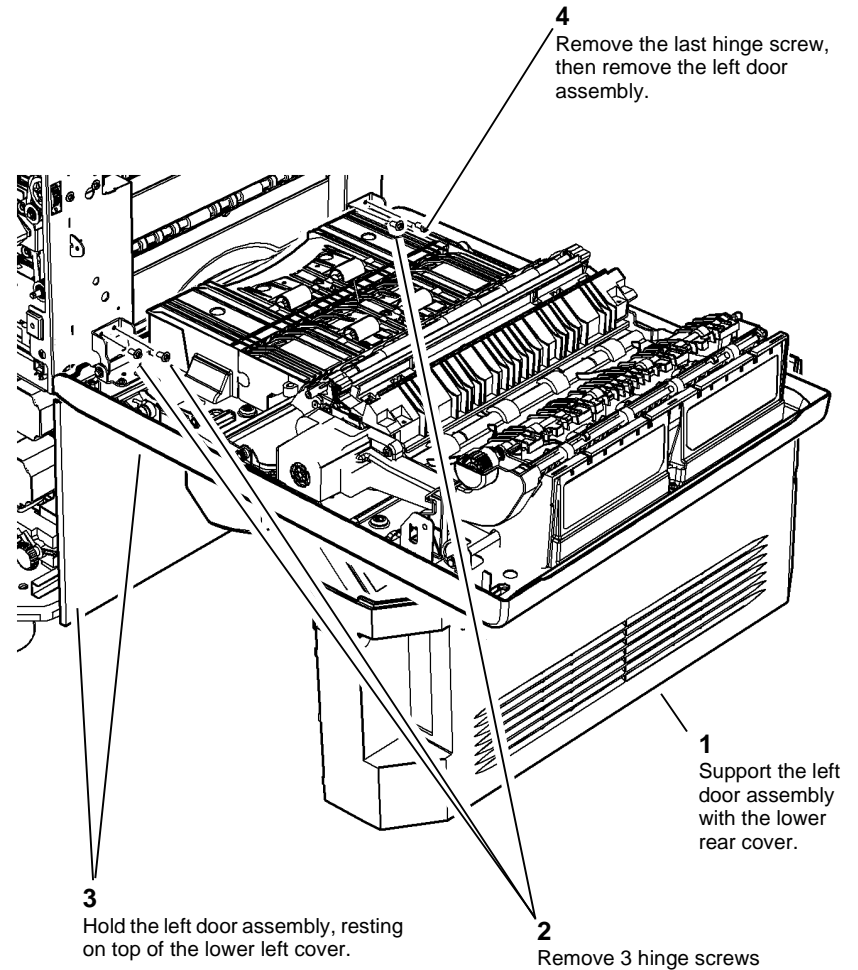
Figure 2 Left door removal

6. Remove the left door assembly, [Figure 2](#).

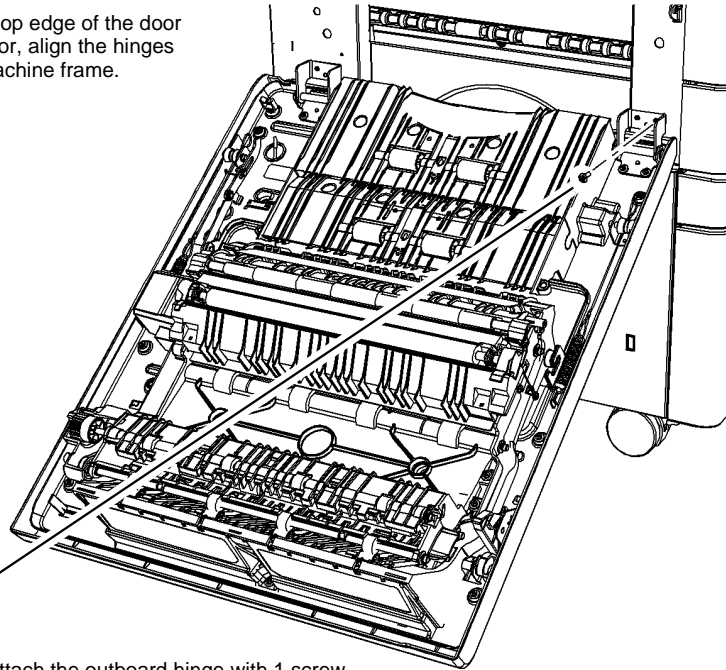
Figure 3 Temporary alignment

With the top edge of the door on the floor, align the hinges on the machine frame.

Loosely attach the outboard hinge with 1 screw.

3. Ensure that the location holes of the left door assembly hinges locate correctly with small dowel pins on the IOT frame, Figure 5. Fully tighten the 4 hinge screws, refer to Figure 3 and Figure 4.

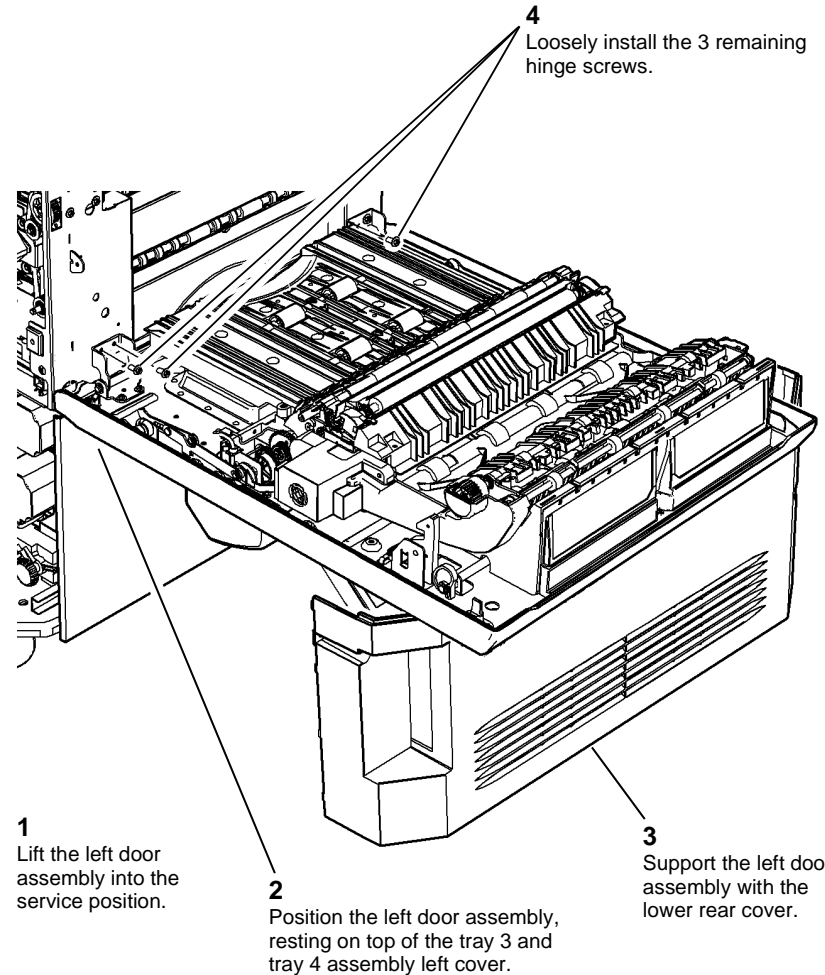
Figure 4 Left door assembly Installation

2. Install the left door assembly, Figure 4.

Lift the left door assembly into the service position.

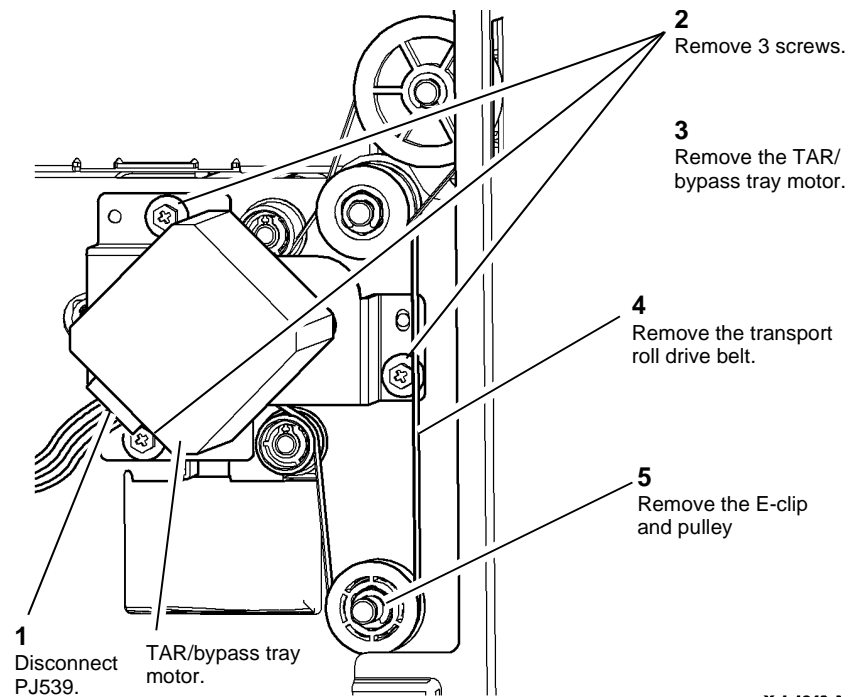
Figure 1 TAR/Bypass tray motor

1. Remove the bypass tray drive belt, [REP 80.6](#).
2. Remove the TAR/Bypass tray motor, [Figure 1](#).

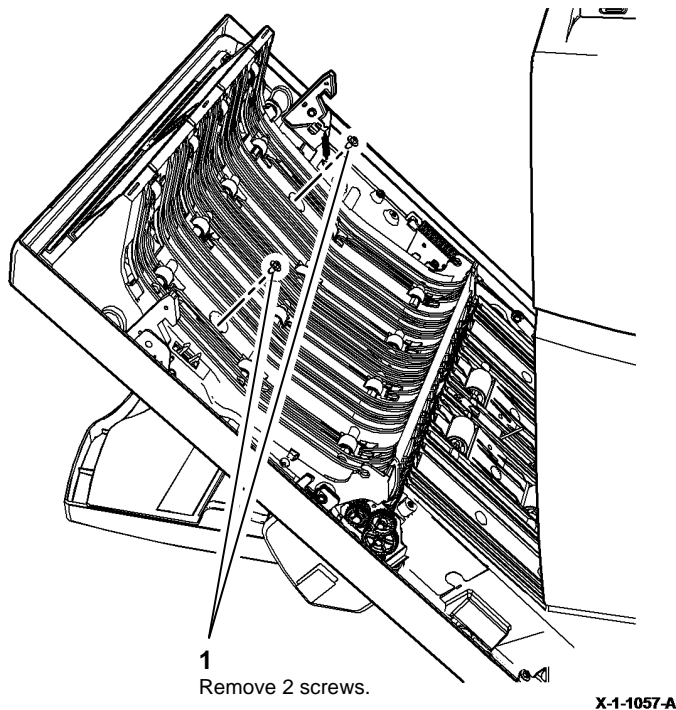
Figure 1 Preparation

1. Open the left door, [PL 80.10 Item 1](#).
2. Remove the print cartridge, [PL 90.17 Item 9](#), then place in a black bag.
3. Remove the left door fan cover, [PL 80.10 Item 4](#).
4. Remove the duplex transport assembly, [REP 80.5](#).
5. Prepare to remove the duplex outer guide assembly, [Figure 1](#).

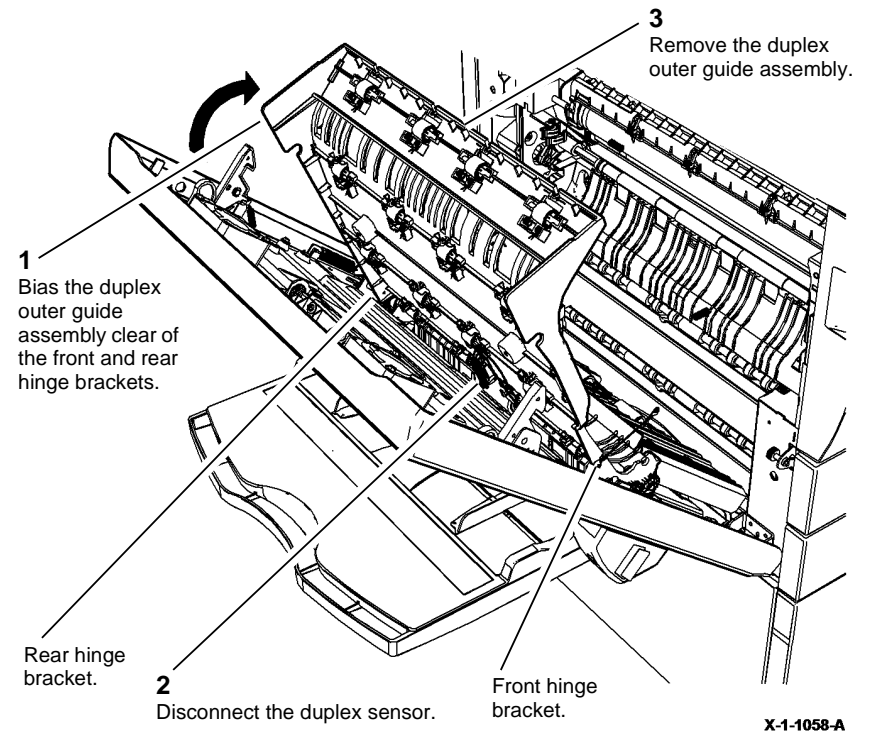
Figure 2 Removal

6. Remove the duplex outer guide assembly, [Figure 2](#).

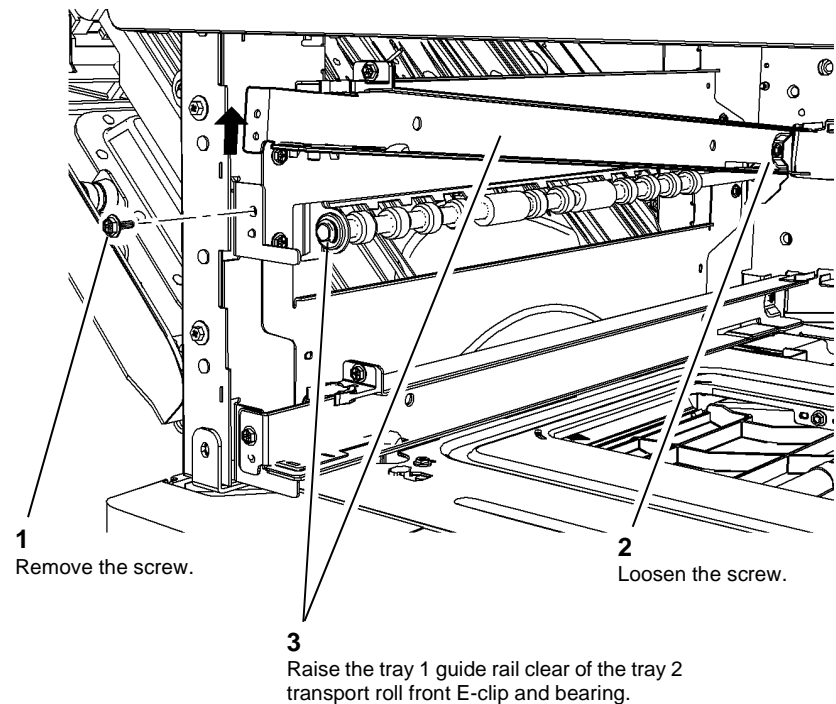
6. Raise the tray 1 guide rail to increase access to the tray 2 transport roll front E-clip and bearing, [Figure 1](#).

3. Raise the tray 1 guide rail clear of the tray 2 transport roll front E-clip and bearing.

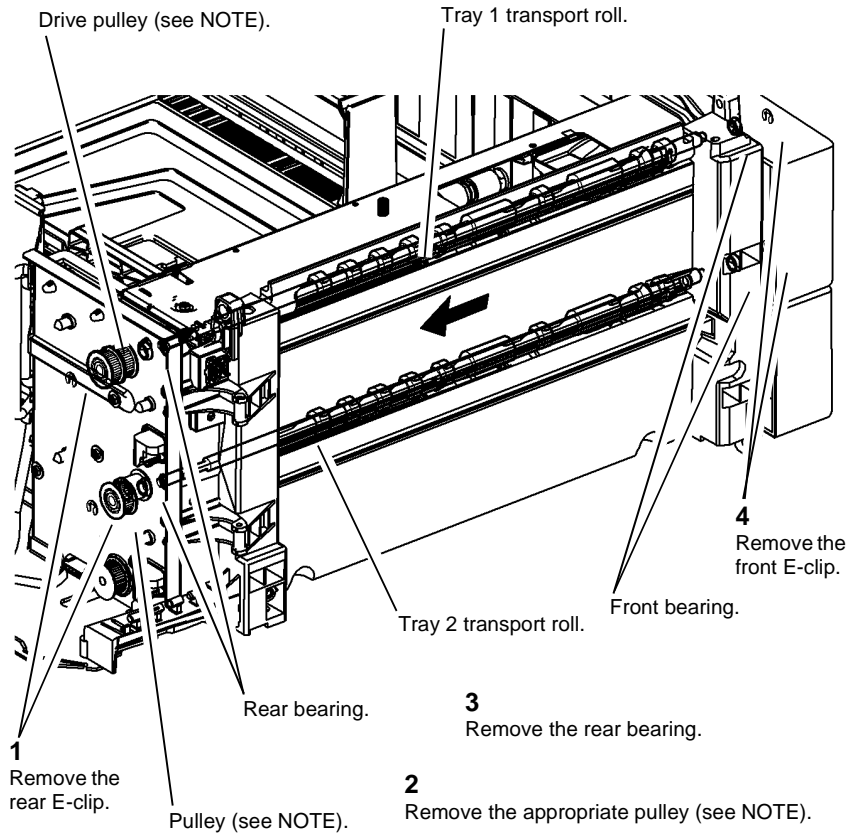
Figure 2 Transport roll removal

Move the transport roll towards the rear of the machine to release it from the front bearing.

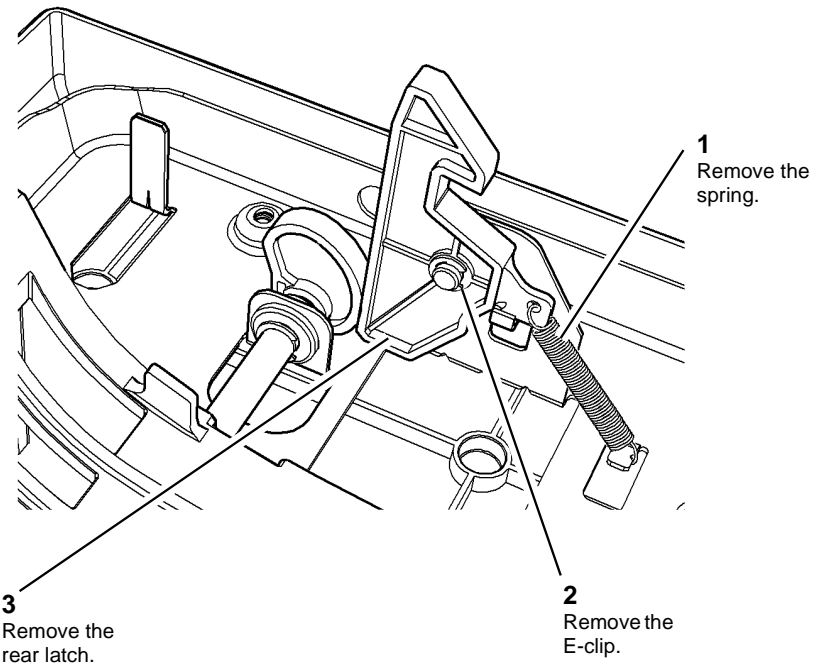
Figure 1 Removal

NOTE: The the following procedure illustrates the removal of the rear latch assembly. The removal procedure for the front latch assembly is the same.

1. Open the left door, [PL 80.10](#) Item 1.
2. Remove the print cartridge, [PL 90.17](#) Item 9, then place in a black bag.
3. Raise the duplex transport assembly, [PL 80.22](#) Item 1.
4. Remove the rear latch assembly, [Figure 1](#).

5. Repeat the steps shown in [Figure 1](#) in order to remove the front latch assembly.

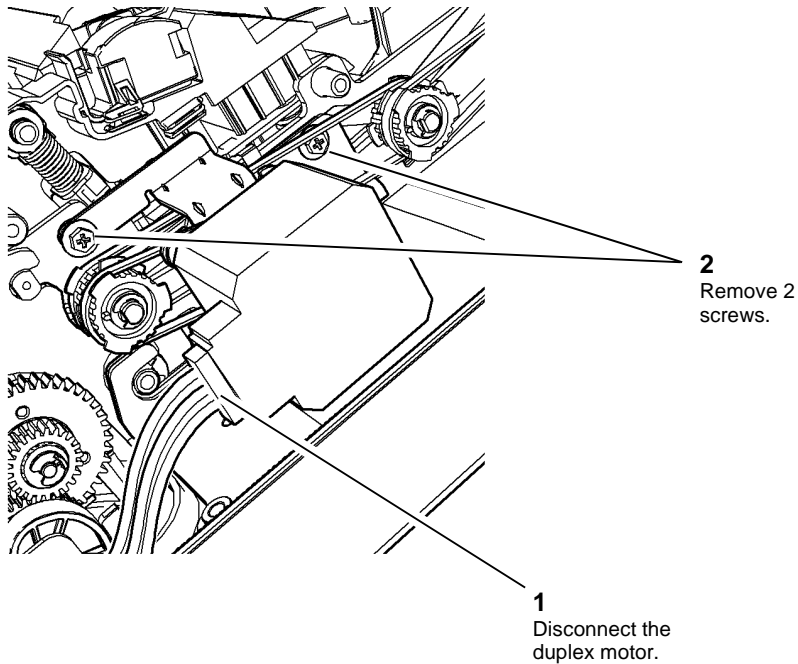
Figure 1 Preparation

1. Open the left door, [PL 80.10 Item 1](#).
2. Remove the print cartridge, [PL 90.17 Item 9](#), then place in a black bag.
3. Remove 2 screws, then remove the duplex drives cover, [PL 80.22 Item 21](#).
4. Prepare to remove the duplex motor assembly, [Figure 1](#).

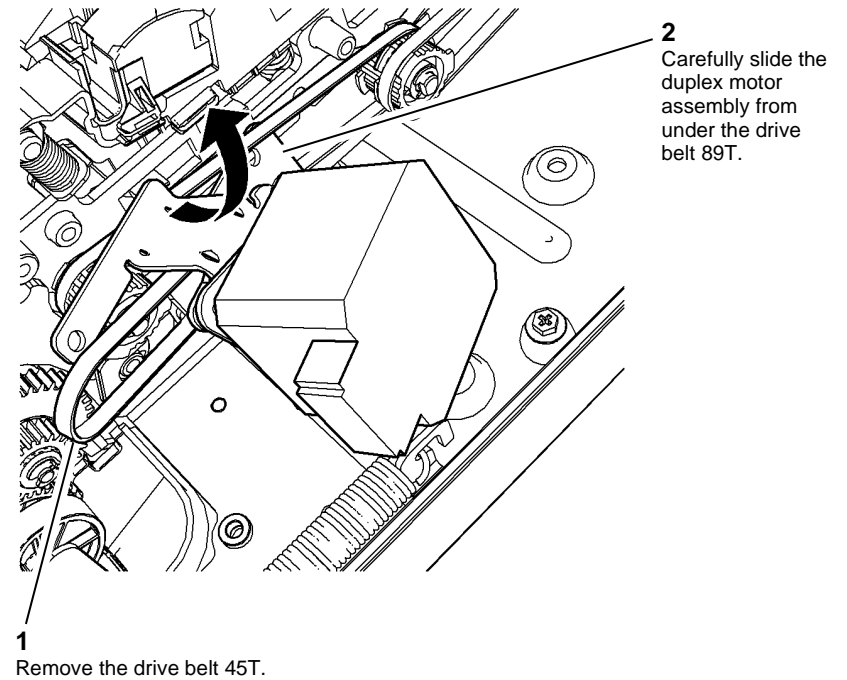
Figure 2 Remove the assembly

5. Remove the duplex motor assembly, [Figure 2](#).

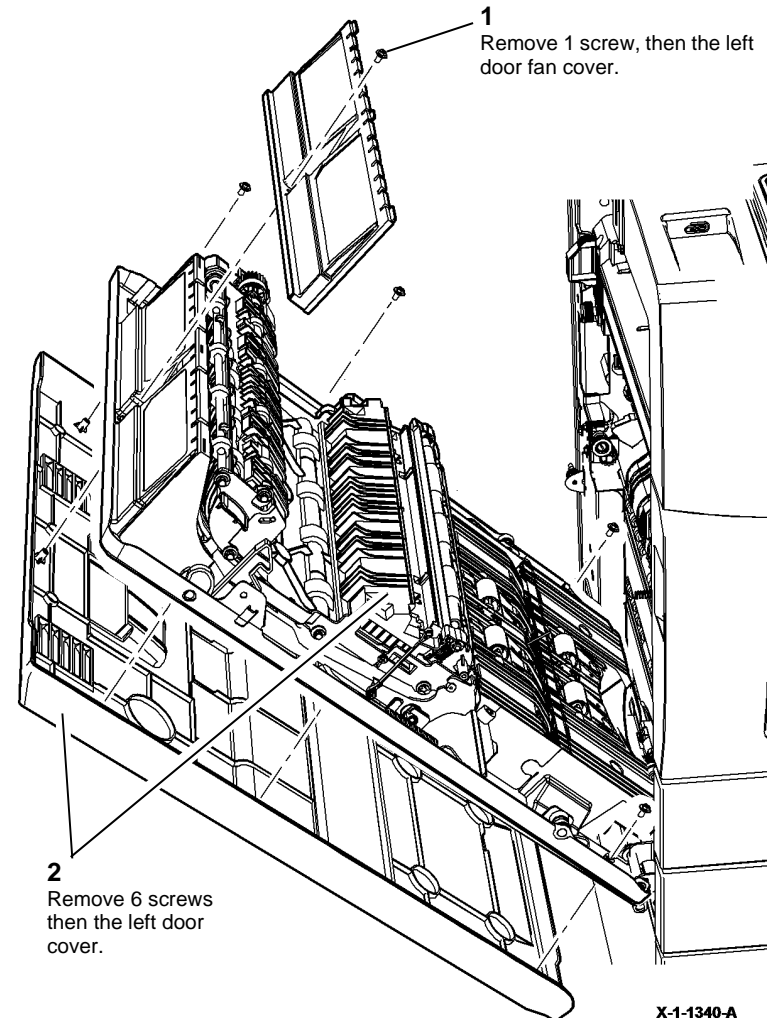
Figure 1 Cover removal

1. Remove the bypass tray assembly, [REP 70.2](#).
2. Remove the left door cover, [Figure 1](#).

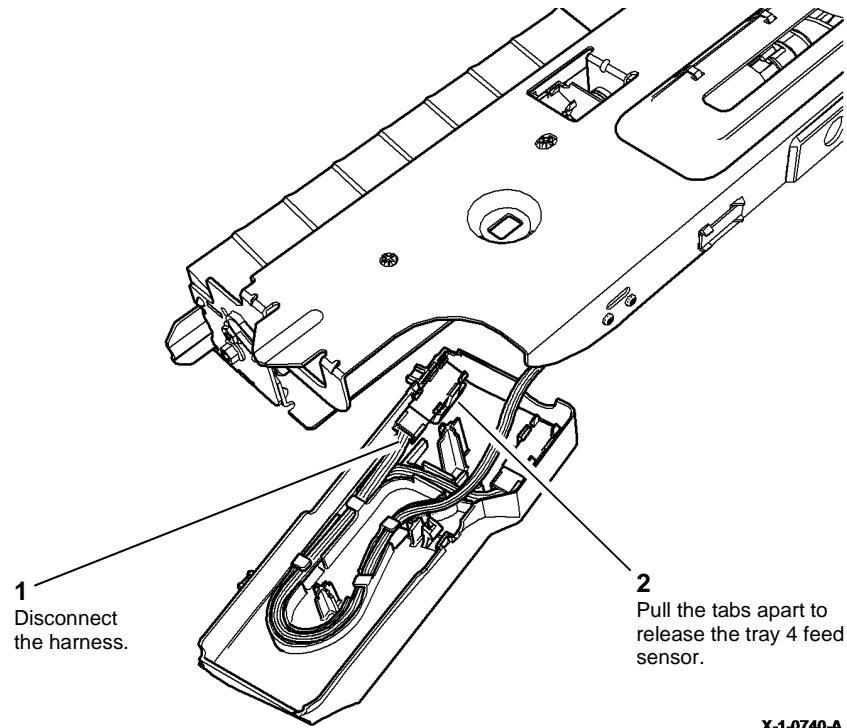
Figure 2 Sensor removal

3. Remove the tray 4 feed sensor, [Figure 2](#).

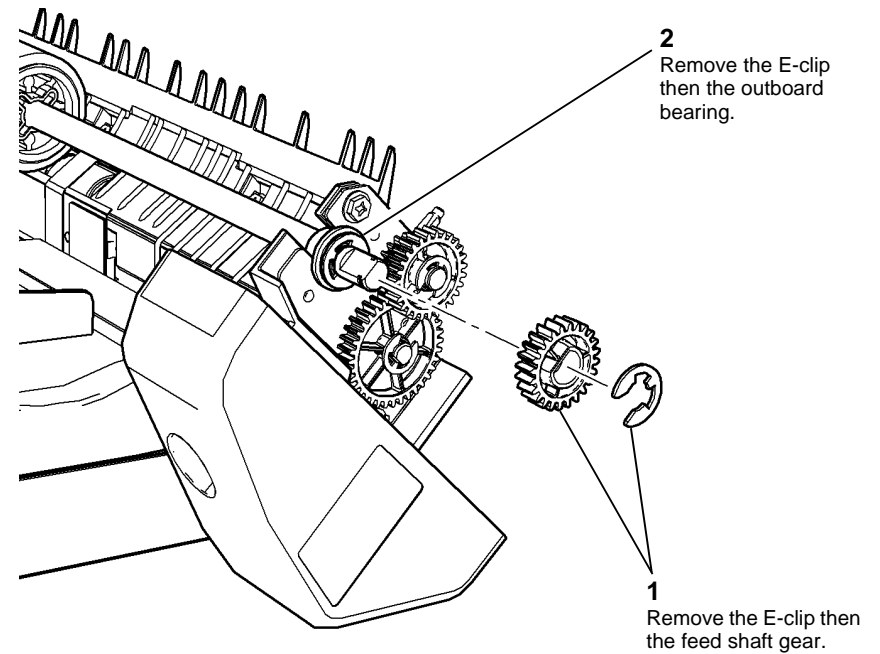
Figure 1 Feed roll front fixings

1. Remove the bypass tray assembly, [REP 70.2](#).
2. Prepare to remove the feed roll assembly, [Figure 1](#).

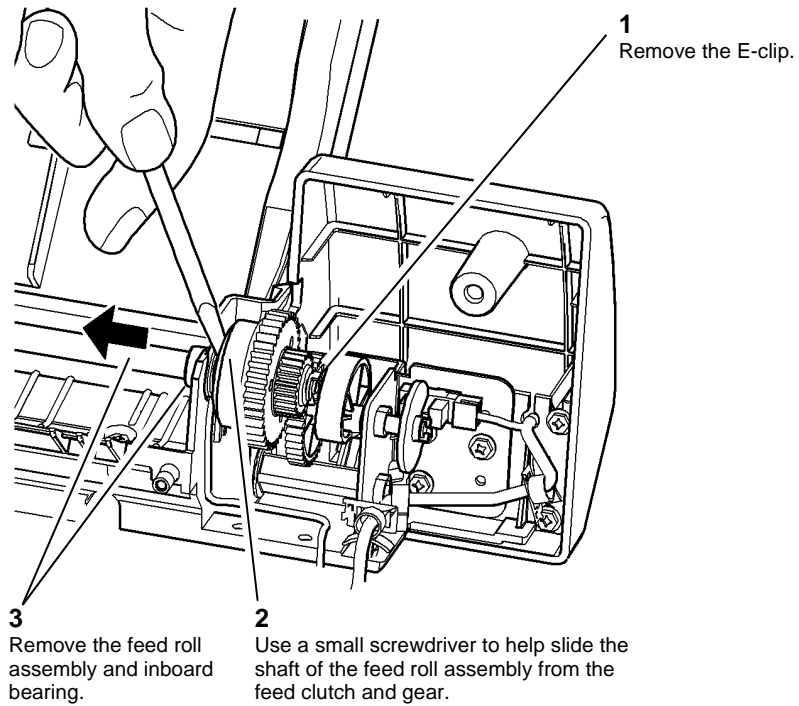
Figure 2 Feed roll and clutch assemblies

3. Remove the feed clutch and feed roll assembly, [Figure 2](#).

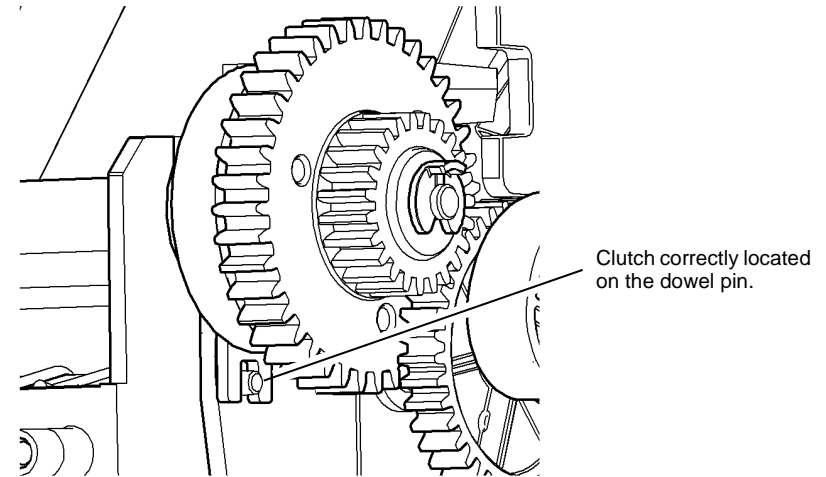
Figure 3 Dowel pin

1. Replacement is the reverse of the removal procedure.
2. Ensure the clutch locates with the dowel pin on the feeder frame, [Figure 3](#).

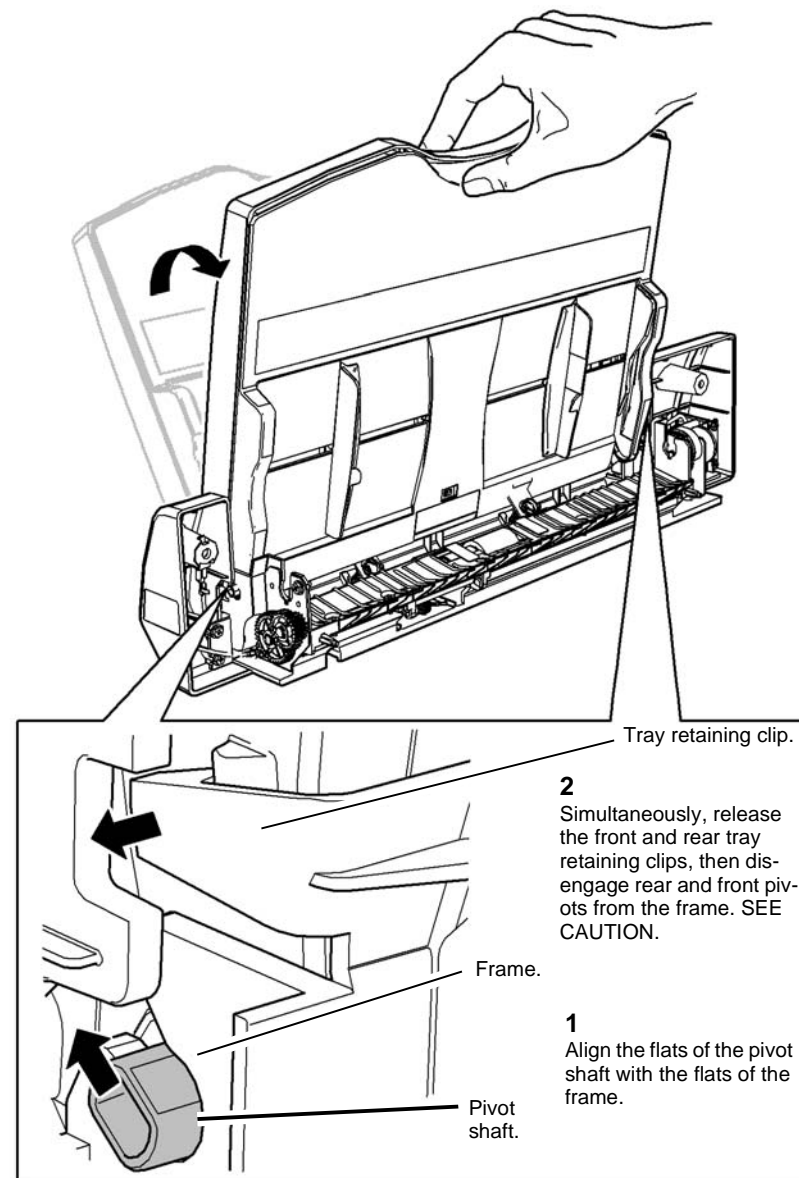
Figure 1 Bypass tray release

Take care not to damage the wiring harness between the tray assembly and the feeder frame.

2. Release the tray assembly, [Figure 1](#).

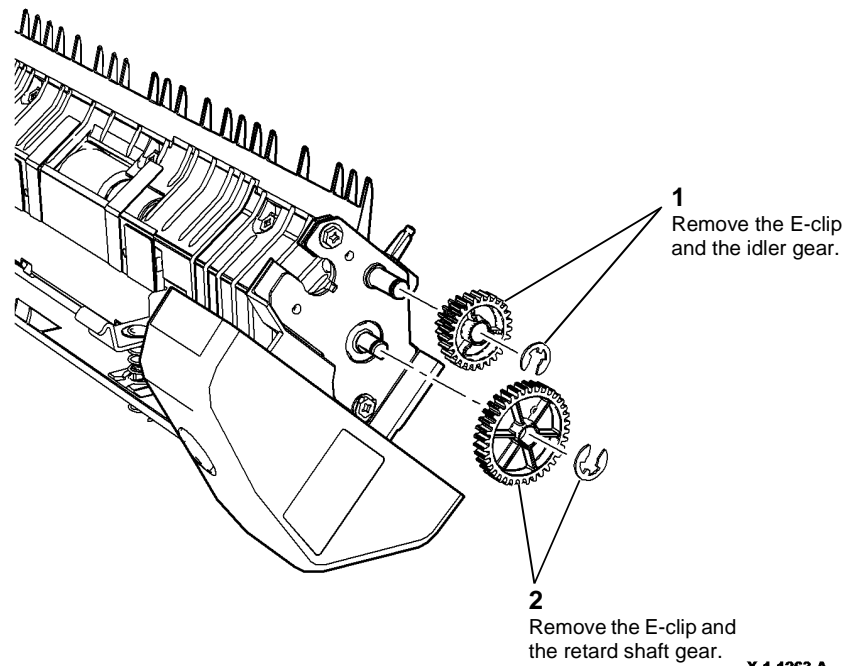
Figure 2 Gears removal

3. Remove the front gears, [Figure 2](#).

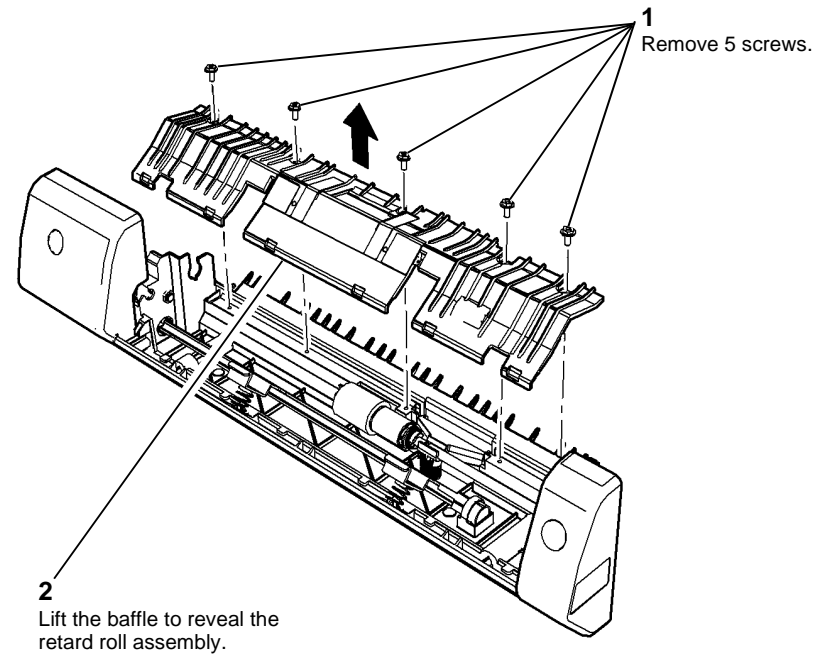
Figure 3 Baffle release

4. Release the baffle, [Figure 3](#).

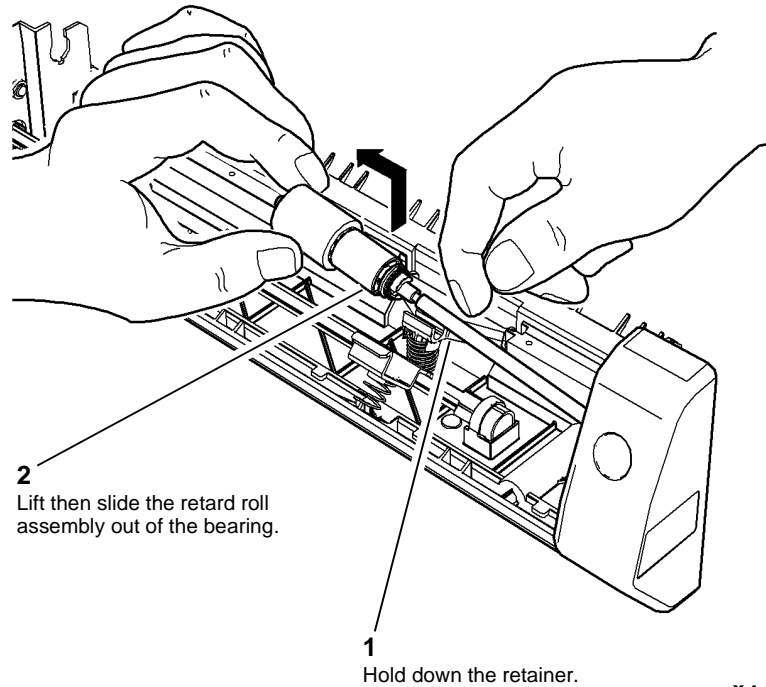
Figure 4 Retard roll removal

5. Remove the retard roll assembly, [Figure 4](#).

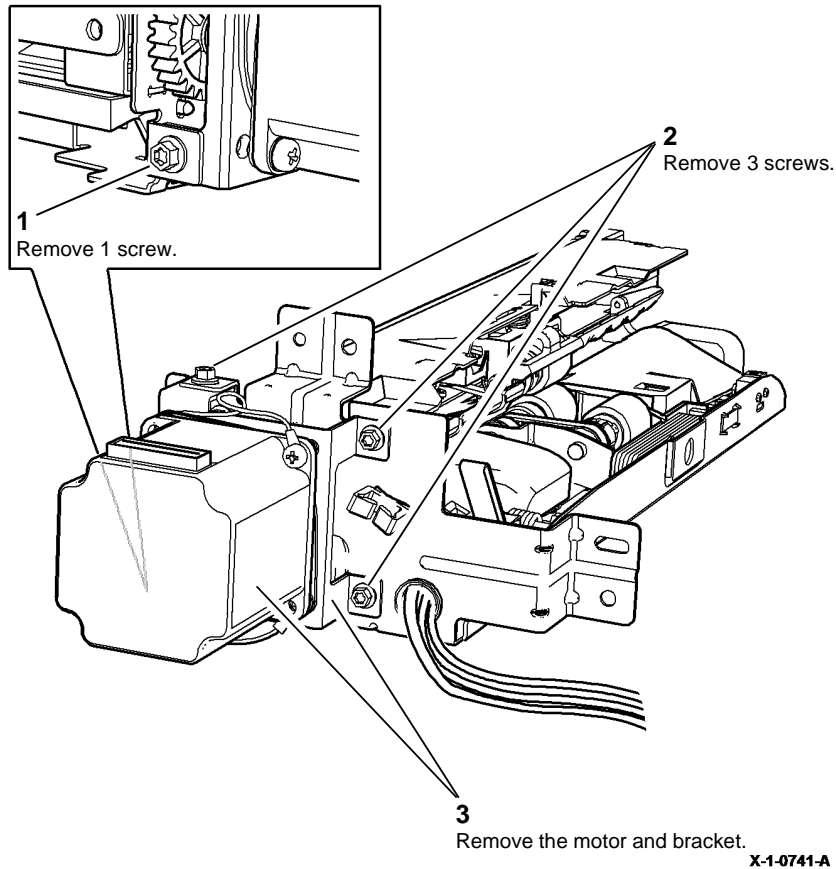
Figure 1 Motor and bracket removal

3. Remove the feed motor with the bracket, [Figure 1](#).

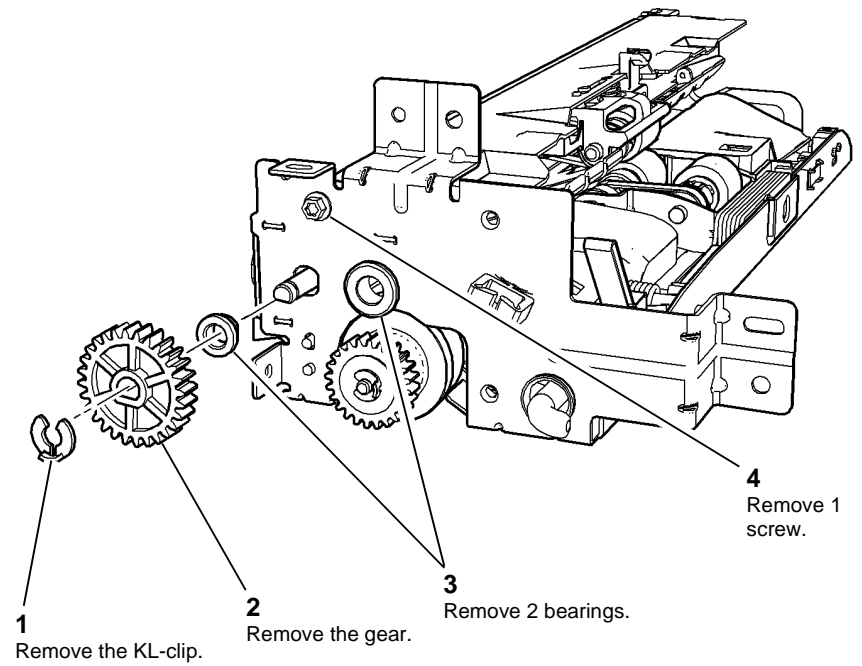
Figure 2 Rear fixings

4. Release the rear fixings, [Figure 2](#).

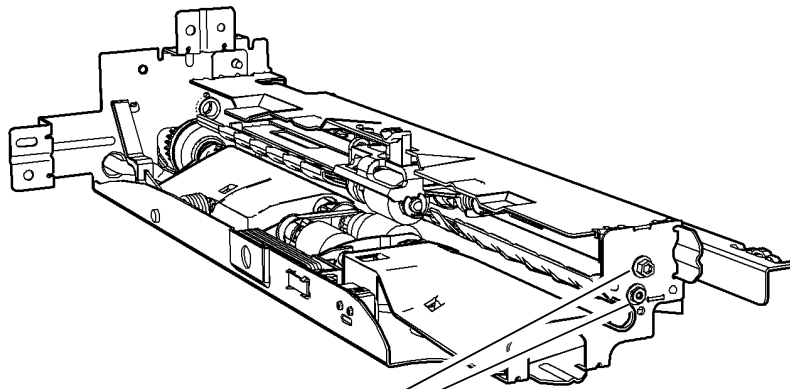
Figure 3 Front fixings

5. Release the front fixings, [Figure 3](#).

1
Remove 2 screws.

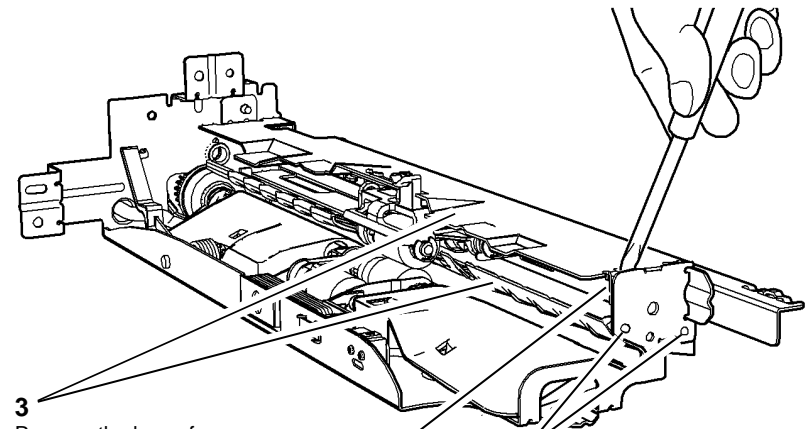
6. Separate the upper and lower frames, [Figure 4](#).

3
Remove the lower frame
and paper guide.

2
Ensure the plastic pins of the paper
guide are disengaged from the
holes in the lower frame.

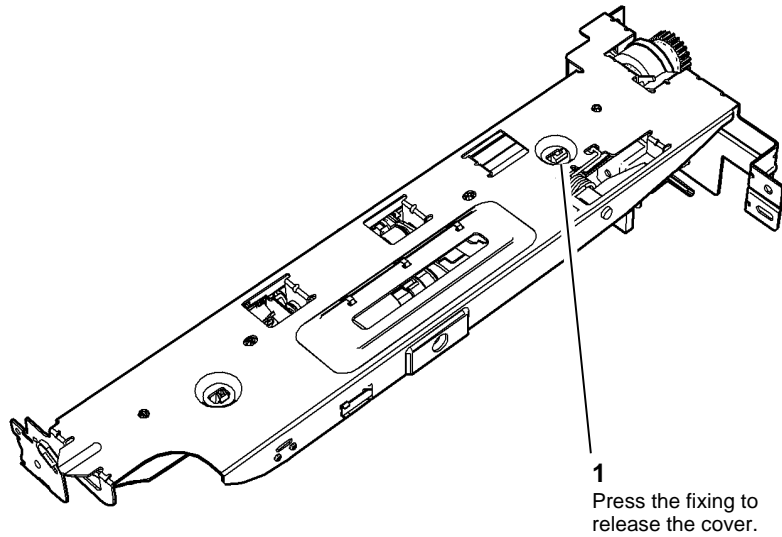
Figure 5 Cover removal

7. Remove the plastic cover, [Figure 5](#).

5. Fasten the plastic cover into position ensuring that the wiring is not trapped, refer to [Figure 5](#).

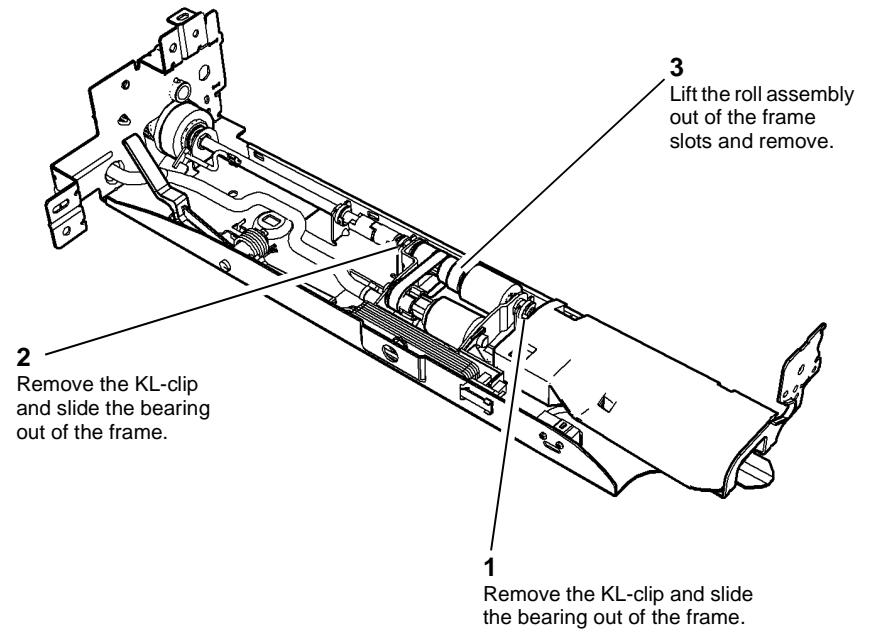
Figure 6 Nudger and feed roll removal

8. Remove the nudger roll and feed roll assembly, [Figure 6](#).

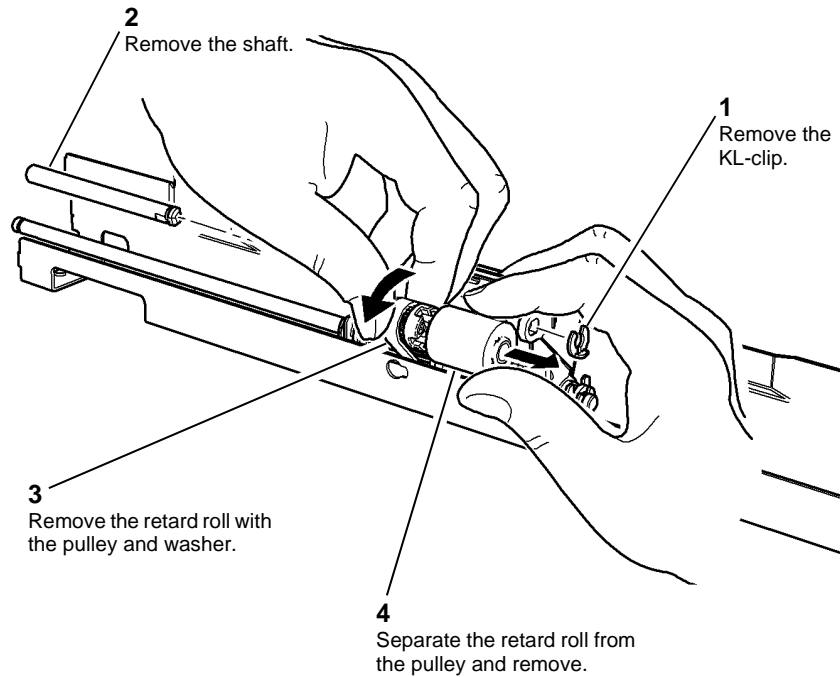
Figure 7 Retard roll removal

9. Remove the retard roller, [Figure 7](#).

1. Install the retard roll by reversing the steps in [Figure 7](#).
2. If necessary refer to [Figure 8](#) for the correct assembly of the retard roll components.

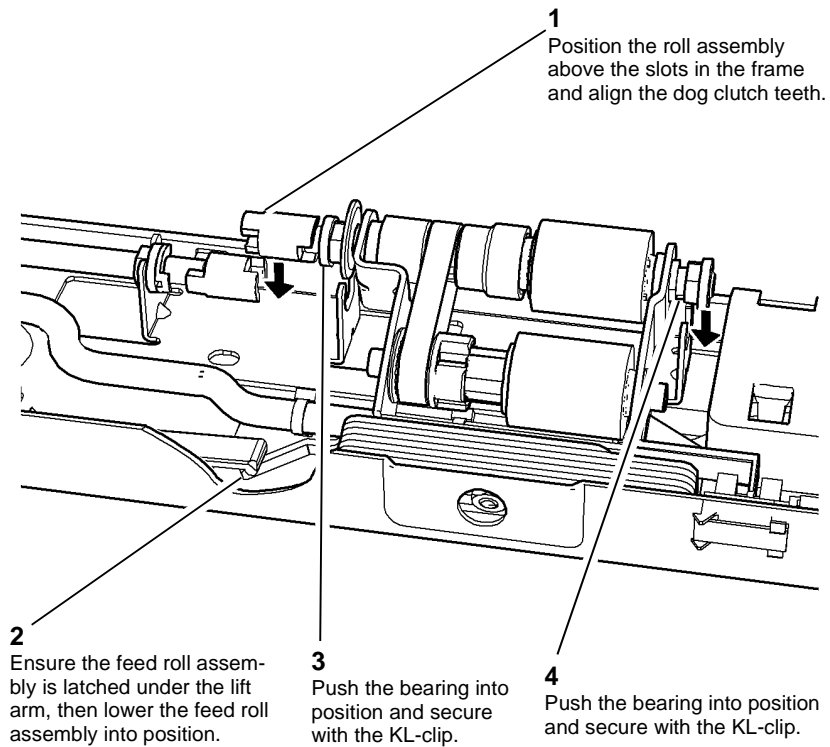
Figure 9 Nudger and feed roll install

3. Check that the number of weights on the new nudger roll and feed roll assembly is the same as on the old assembly. If necessary, correct the number of weights. Refer to [ADJ 80.3](#).

4. Install the nudger roll and feed roll assembly, [Figure 9](#).

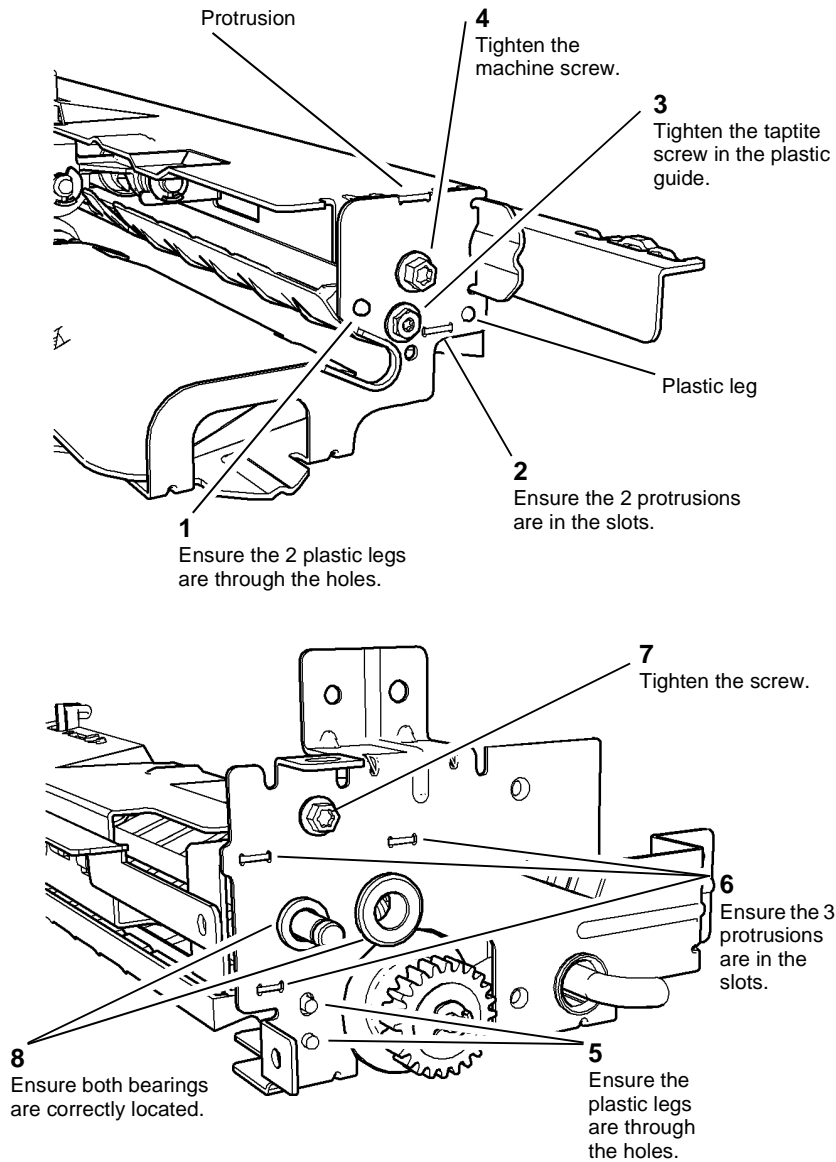
Figure 11 Final assembly

10. Install the feeder assembly into the machine. Check the feeding performance of the HCF.

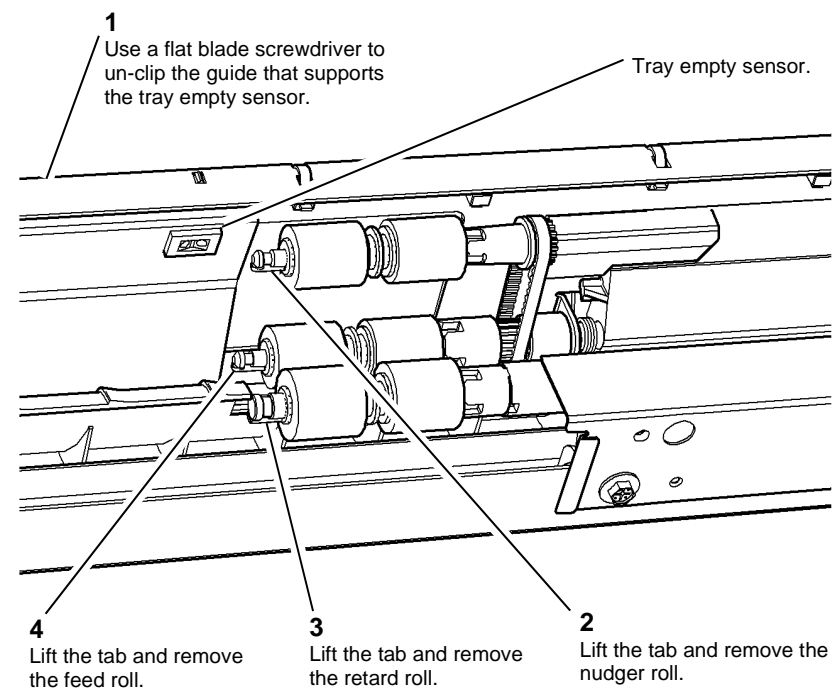
X-1-0705-A

1. Remove tray 1 or tray 2 as required, [REP 70.1](#).
2. Remove tray 1 or tray 2 paper feed assembly as required, [REP 80.1](#).
3. Remove tray 1 or tray 2 feed rolls, [Figure 1](#).

NOTE: The removal procedure is the same for the tray 1 and tray 2 feed, nudger and retard rolls. The feed and nudger rolls are the same diameter, but the retard roll has a larger diameter.

Figure 1 Feed rolls removal

1. The replacement is the reverse of the removal procedure. Refer to [GP 6](#) before refitting the screws.
2. Ensure that the tabs on the feed, nudger and retard rolls are located in their drive shafts.
3. Check that the tray empty sensor is located in the guide, and that the guide is located correctly and secure on the feeder frame.
4. Check the registration. Refer to [dC604](#) Registration Setup Procedure.
5. If a new feed, nudger and retard roll are installed, reset the tray 1 or tray 2 feed roll HFSI count. Refer to [dC135](#) CRU/HFSI Status.

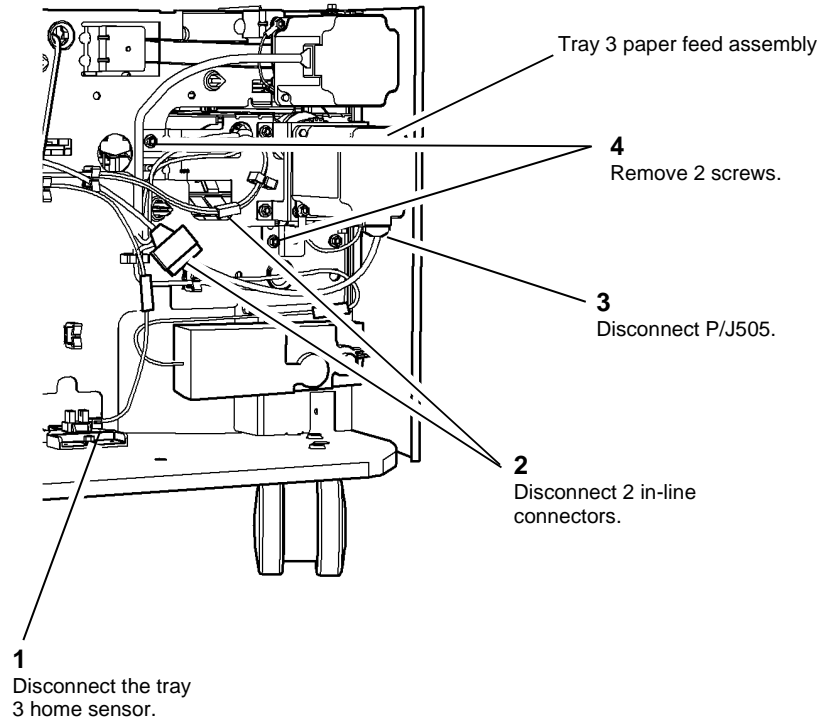
X-1-0716-A

Carefully slide out the tray 3 paper feed assembly, ensuring that harnesses are not damaged.

Ensure the harnesses of the tray 3 paper feed assembly are released from their cable ties.

Figure 1 Feed assembly removal

6. Push tray 3 in slowly and check that the tray does not foul the paper feed assembly.
7. Connect the 5 PJs, refer to [Figure 1](#).
8. The remainder of the replacement is the reverse of the removal procedure. Refer to [GP 6](#) before refitting the screws.
9. If a new paper feed assembly has been installed, reset the tray 3 feed roll HFSI count. Refer to [dC135](#) CRU/HFSI Status.

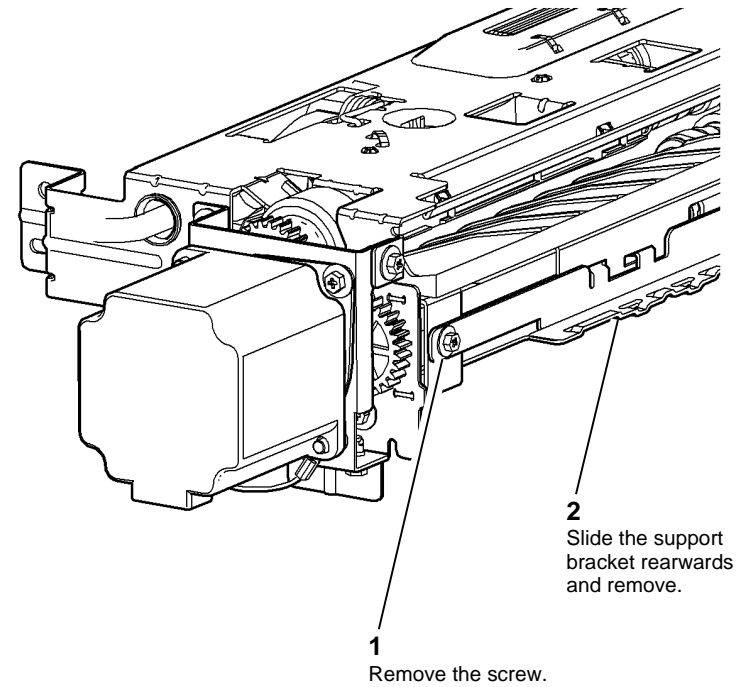
X-1-0717-A

1. If a new tray 3 paper feed assembly is being installed, perform steps 2 to 9. If the old tray 3 paper feed assembly is being re-installed, perform steps 5 to 9.
2. Remove the support bracket, [Figure 2](#).

Figure 2 Support bracket removal

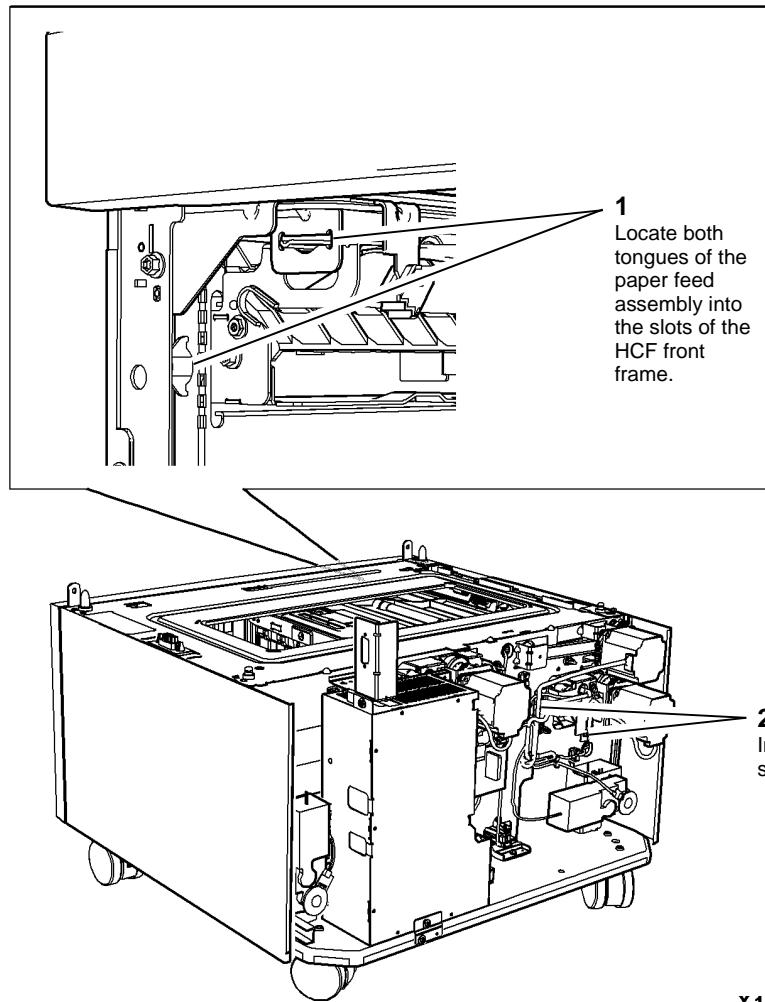
5. Install the paper feed assembly, [Figure 3](#).

Figure 3 Feed assembly installation

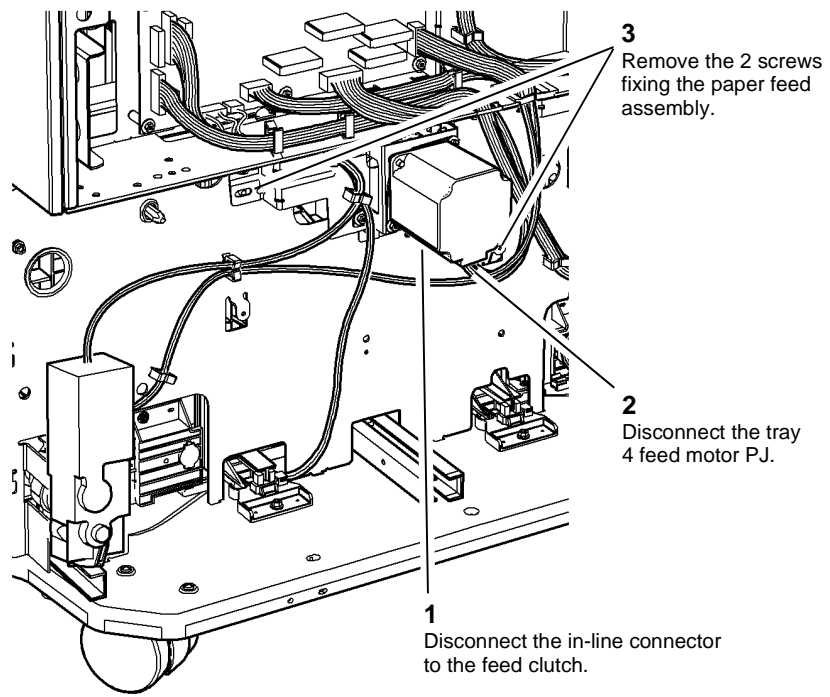
1. Remove the LVPS module, [REP 1.1](#).
2. Pull out tray 4.
3. Remove the tray 4 paper feed assembly, [Figure 1](#).

4
Ensure the harnesses of the tray 4 paper feed assembly are released from their cable ties.

5
Carefully remove the paper feed assembly, from the rear of the machine.

3. Ensure that the tray slide, at the rear right of the tray 4 transport assembly, straddles the support bracket when the paper feed assembly is replaced.
4. Push tray 4 in slowly and check that the tray does not foul the paper feed assembly.
5. Connect the PJs, refer to [Figure 1](#).
6. The remainder of the replacement is the reverse of the removal procedure. Refer to [GP 6](#) before refitting the screws.
7. If a new paper feed assembly has been installed, reset the tray 4 feed roll HFSI count. Refer to [dC135 CRU/HFSI Status](#).

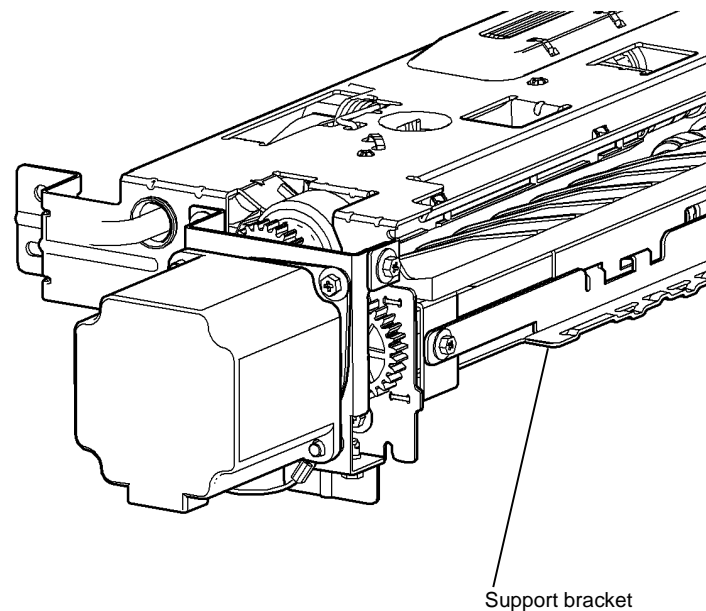
X-1-0714-A

1. Ensure the support bracket is present on the tray 4 paper feed assembly, [Figure 2](#).

Figure 2 Support bracket
