708P91368
September 2017

Xerox® AltaLink® B8090 Family Multifunction Printer Service Manual

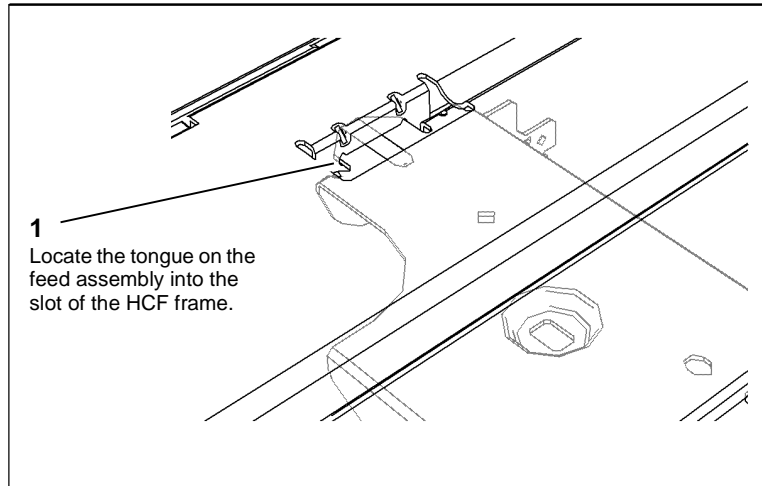
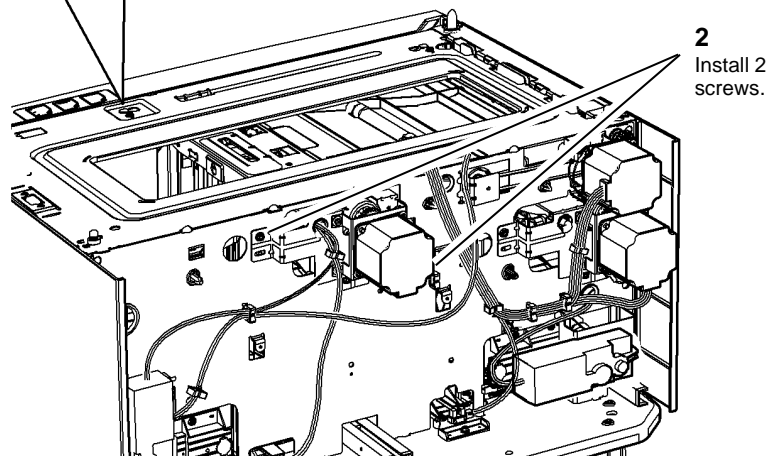
2. Install the paper feed assembly, [Figure 3](#).

Figure 3 Feed assembly installation

3. Ensure that the tray slide, at the rear right of the tray 4 transport assembly, straddles the support bracket when the paper feed assembly is replaced.
4. Push tray 4 in slowly and check that the tray does not foul the paper feed assembly.
5. Connect the PJs, refer to [Figure 1](#).
6. The remainder of the replacement is the reverse of the removal procedure. Refer to [GP 6](#) before refitting the screws.
7. If a new paper feed assembly has been installed, reset the tray 4 feed roll HFSI count. Refer to [dC135 CRU/HFSI Status](#).

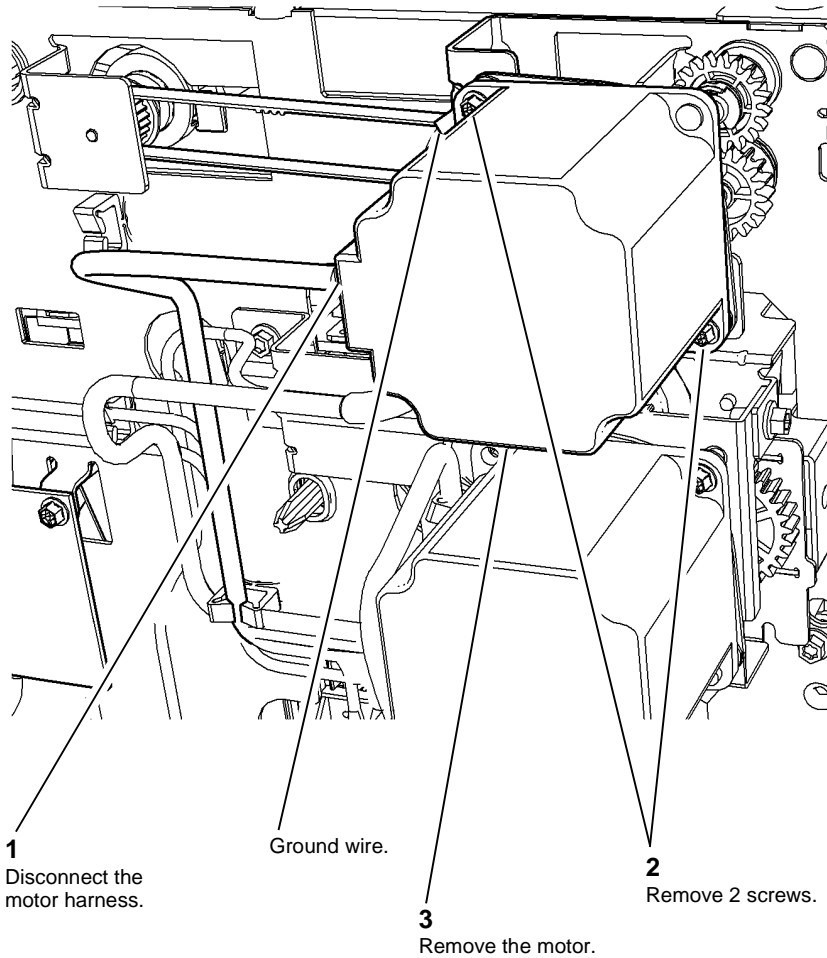
1. Remove the lower rear cover, [PL 70.26 Item 1](#).
2. Remove the HCF transport motor, [REP 80.22](#).
3. Remove the transport gear pulley, [Figure 1](#).

1
Disconnect the
motor harness.

Ground wire.

1. Replacement is the reverse of the removal procedure. Ensure that the ground wire is installed between the motor and the frame, [Figure 1](#).

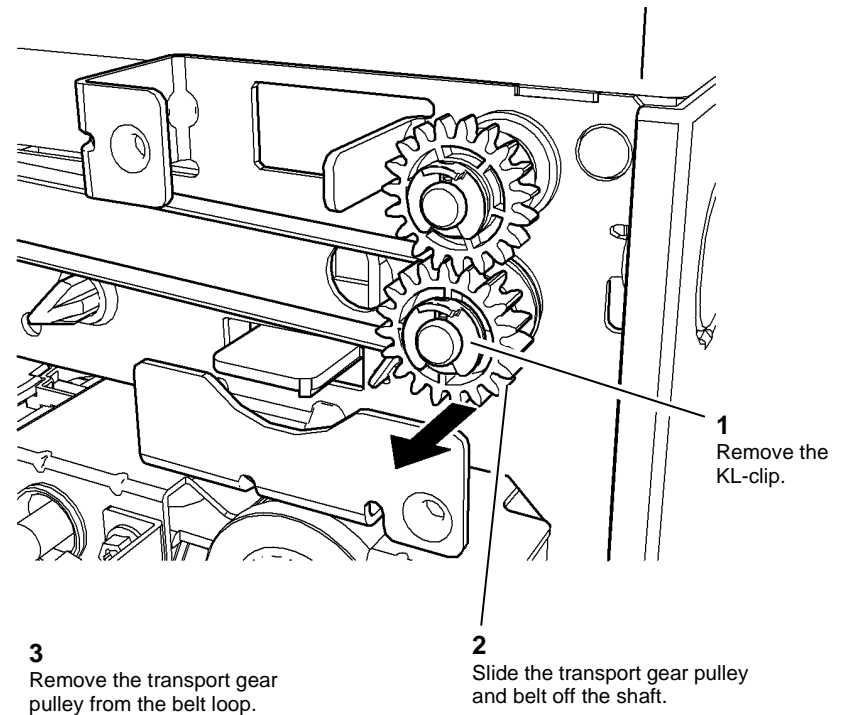
1
Remove the
KL-clip.

3
Remove the transport gear
pulley from the belt loop.

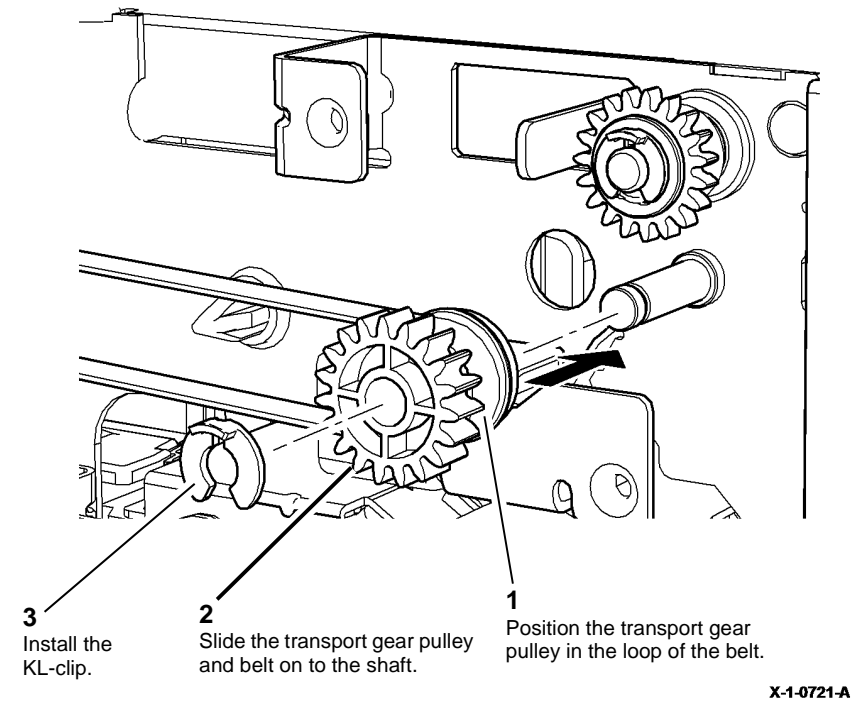
1. Install the transport gear pulley, [Figure 2](#).

Figure 2 Drive belt installation

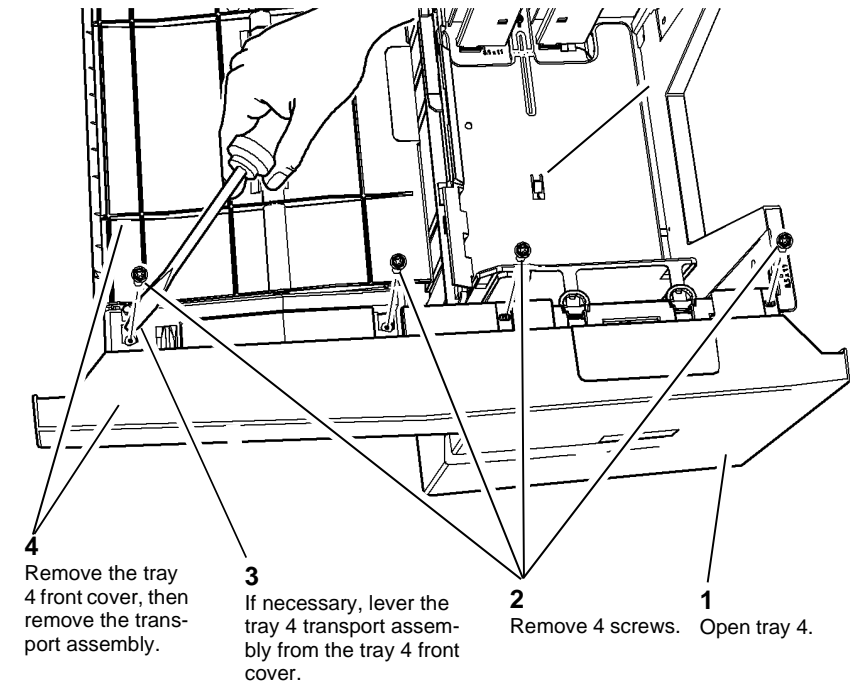
1. Remove the tray 4 transport assembly, [Figure 1](#).

Figure 1 Transport assembly removal

1. Ensure that the tray slide at the rear right of the tray straddles the support bracket when the tray is replaced.
2. The remainder of the replacement is the reverse of the removal procedure. Refer to [GP 6](#) before refitting the screws.

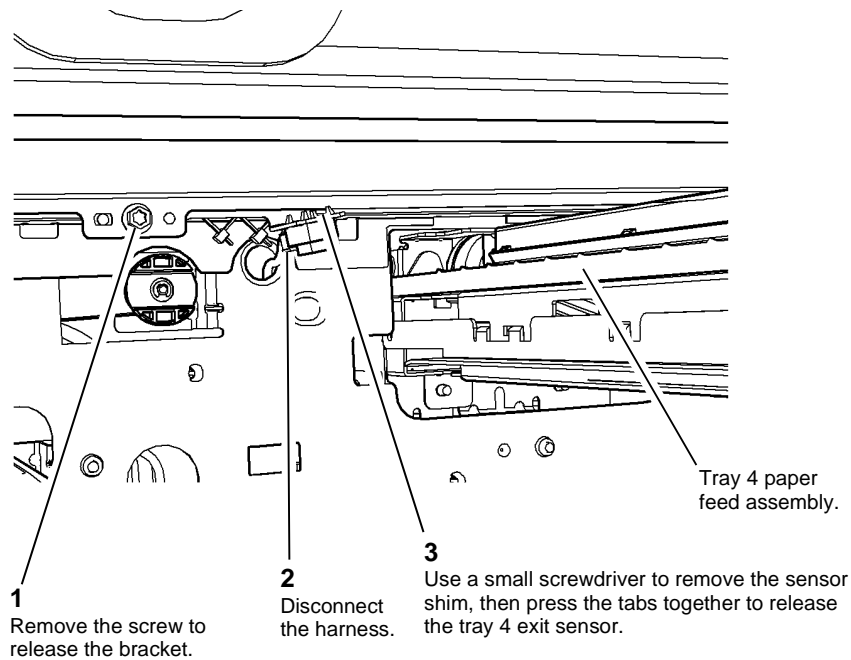
X-1-0723-A

1. Remove the tray 3 assembly, [REP 70.5](#).
2. Remove the tray 4 assembly, [REP 70.13](#).
3. Remove the tray 4 exit sensor, [Figure 1](#).

Figure 1 Tray 4 exit sensor removal

1. Replacement is the reverse of the removal procedure.
2. Install a new sensor shim to lock the sensor in place.

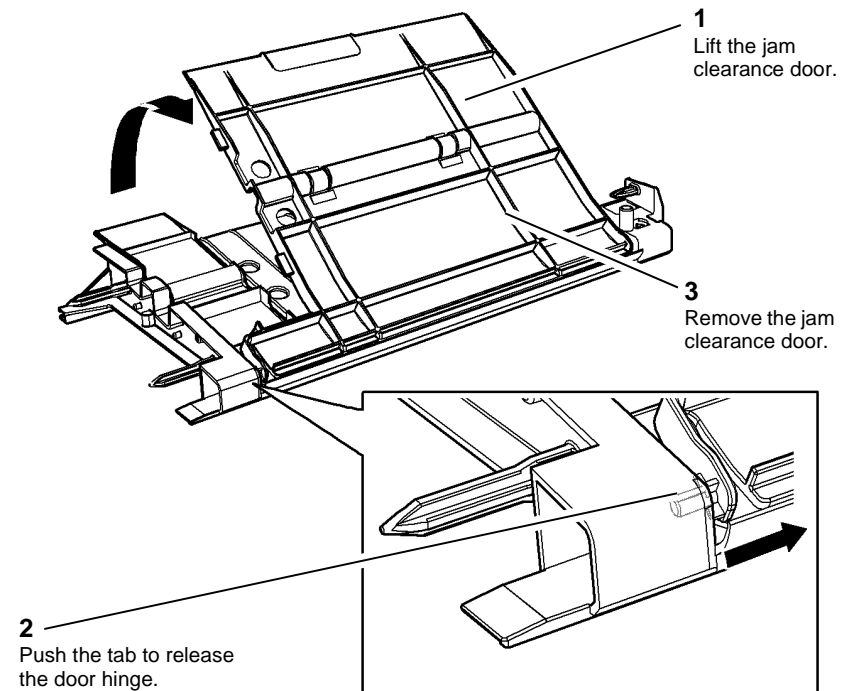
X-1-0724-A

1. Remove the tray 4 transport assembly, [REP 80.24](#).
2. Remove the jam clearance door, [Figure 1](#).

Figure 1 Jam clearance door removal

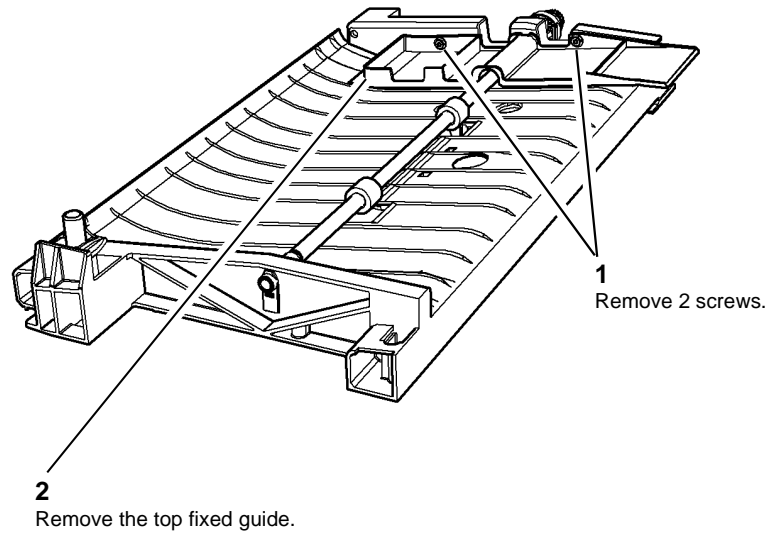
X-1-2017-A

3. Remove the top fixed guide, [Figure 3](#).

Figure 2 Top fixed guide removal

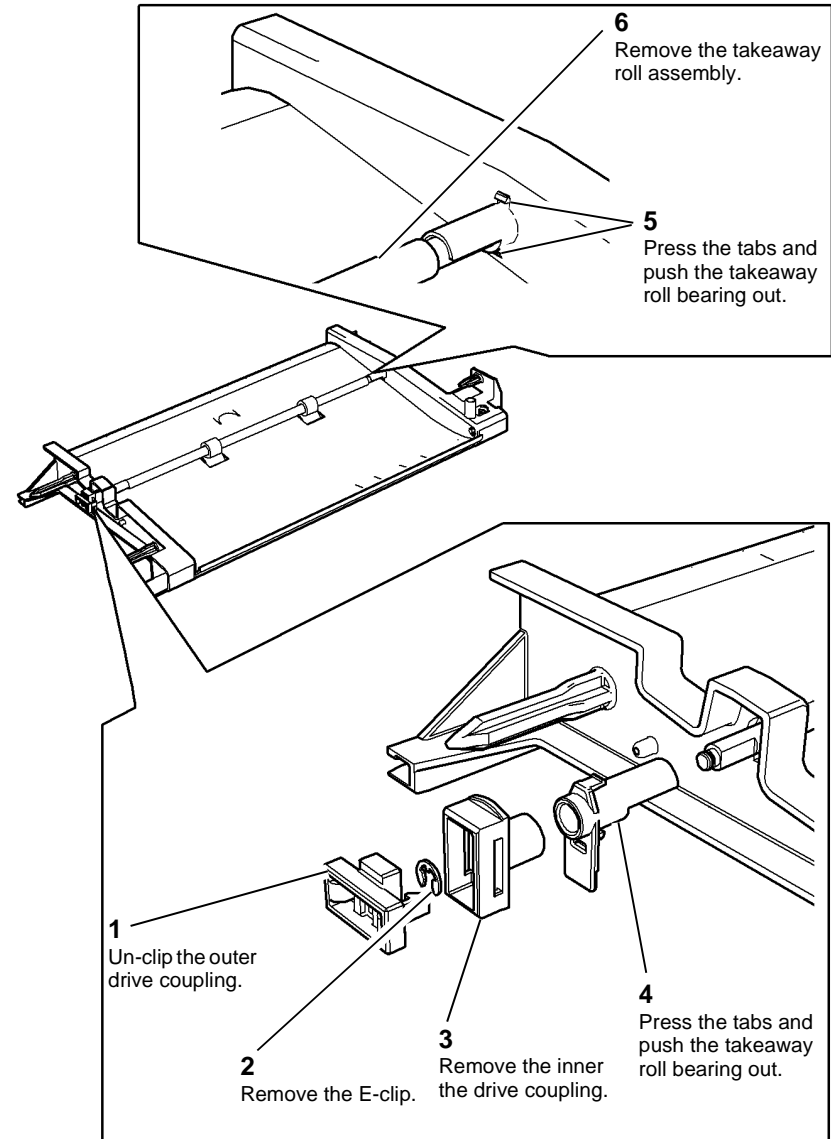
X-1-0725-A

4. Remove the takeaway roll assembly, [Figure 3](#).

Figure 3 Takeaway roll removal

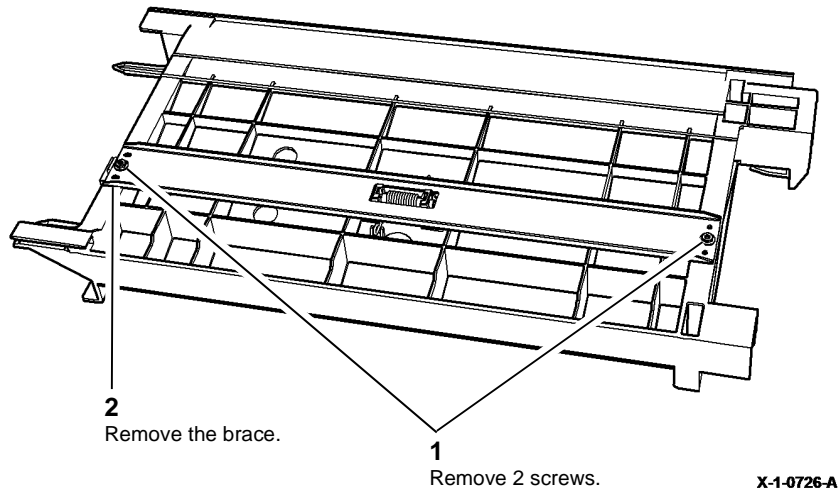
5. If necessary, remove the tray 4 transport brace, [Figure 4](#), and the idler roll assembly, [Figure 5](#).

Figure 4 Brace removal

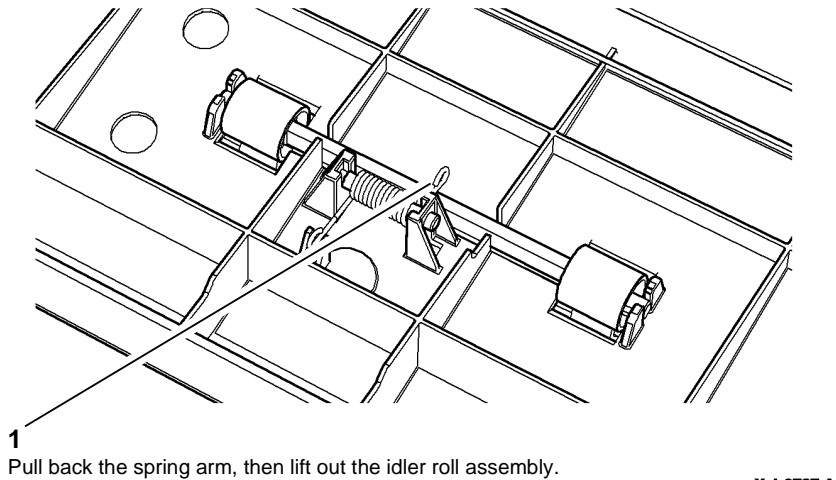
Figure 5 Idler rolls removal

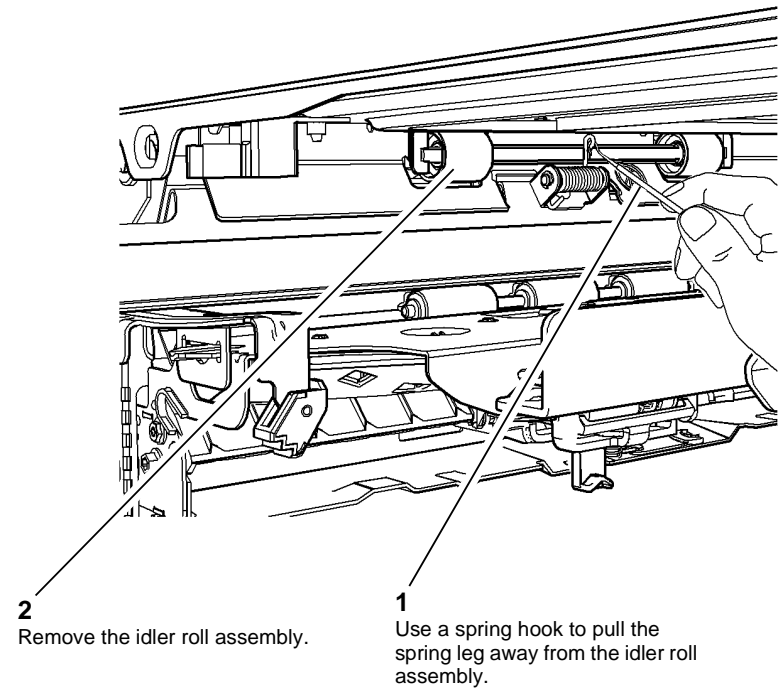
1. Remove the lower left cover, [PL 70.26 Item 7](#).
2. Remove the tray 3 assembly, [REP 70.5](#).
3. Remove the tray 4 transport assembly, [REP 80.24](#).
4. Remove the idler roll assembly, [Figure 1](#).

Figure 1 Idler shaft removal

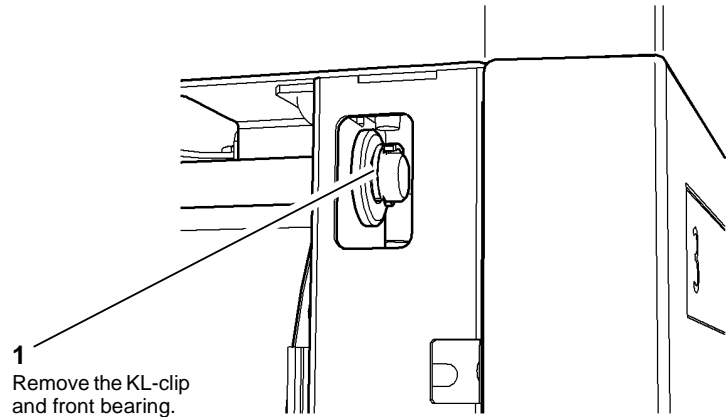
X-1-0729-A

5. Remove the HCF transport motor, [REP 80.22](#).
6. Prepare to remove the HCF transport roll, [Figure 2](#).

Figure 2 Preparation

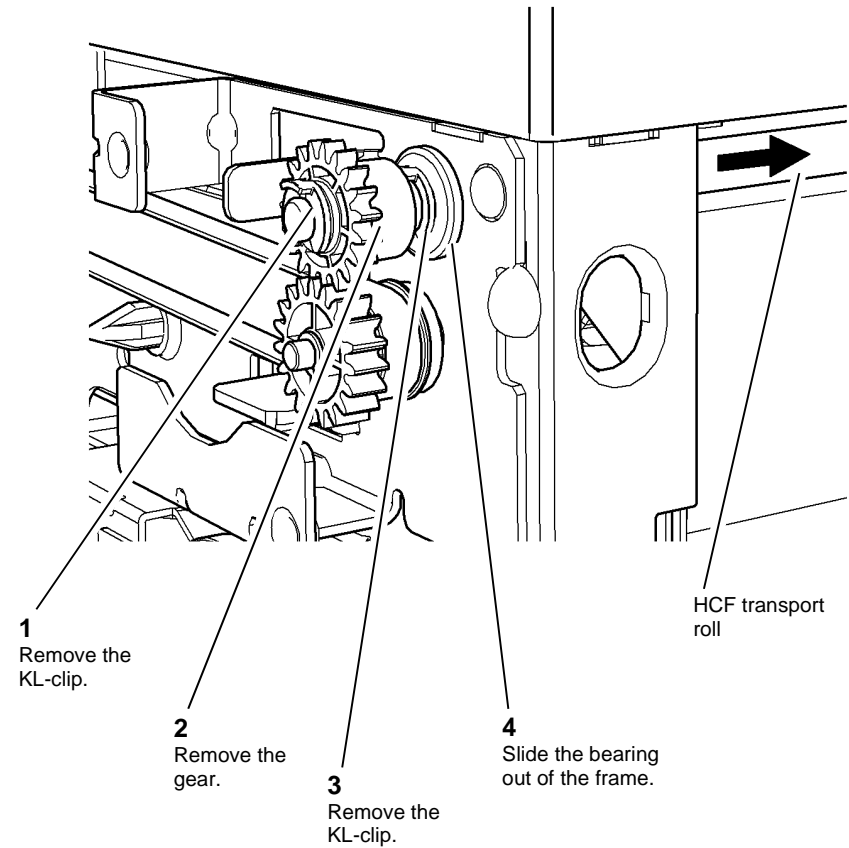
6. Slide the HCF transport roll to the front and remove.

5. Slide the HCF transport roll to the rear to release the roll from the front of the frame.

Figure 3 Transport roll removal

When installing the gear on the shaft, take care not to damage the one-way clutch in the centre of the gear. Before tightening the motor screws, adjust the position of the motor so that there is a very small amount of backlash between the gears.

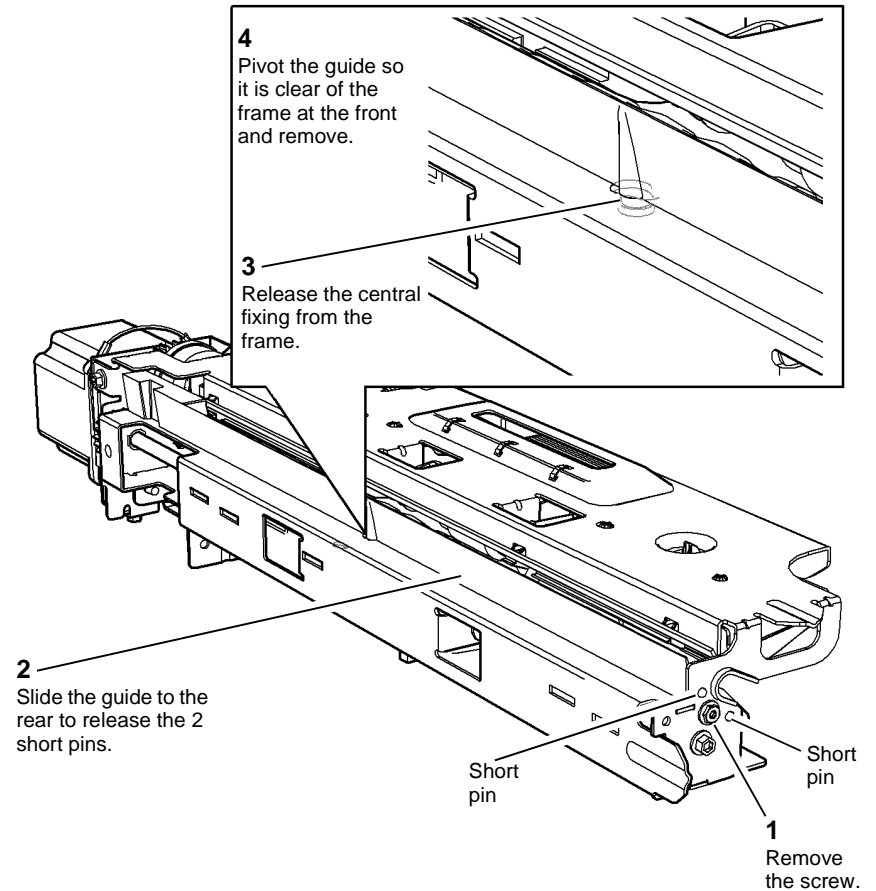
X-1-0754-A

1. Remove the tray 3 paper feed assembly, [REP 80.20](#).
2. Remove the tray 3 paper guide, [Figure 1](#).

Figure 1 Paper guide removal

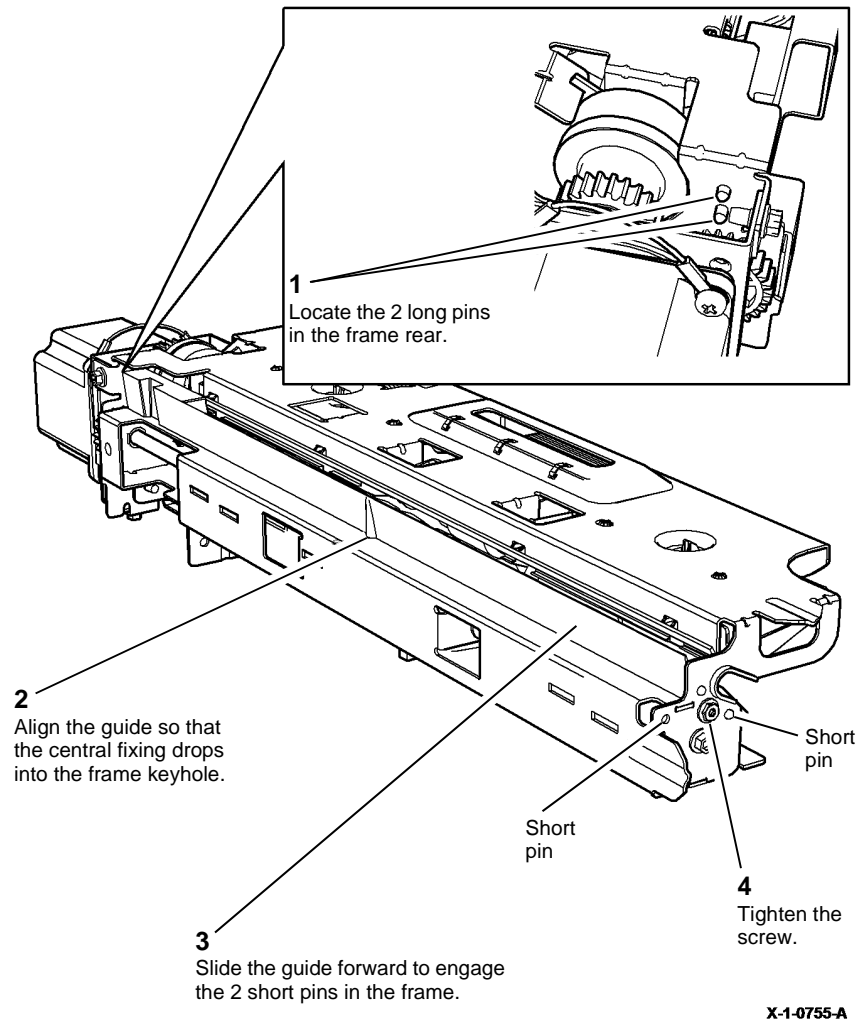
1. Install the tray 3 paper guide, [Figure 2](#).

Figure 2 Paper guide replacement

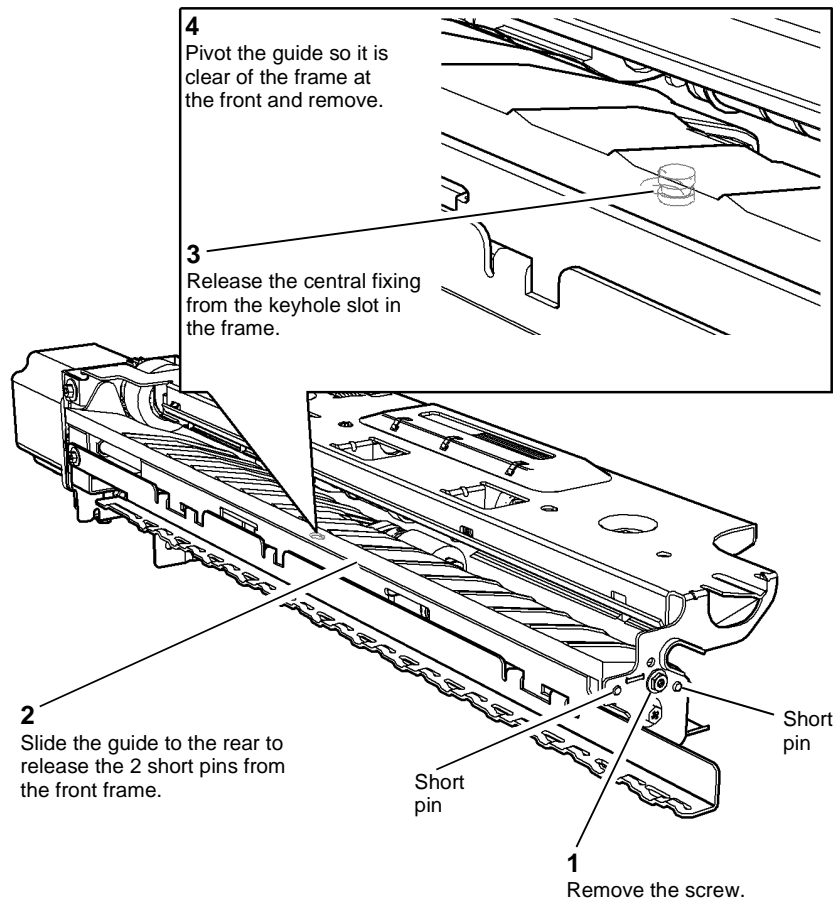
X-1-0752-A

1. Remove the tray 4 paper feed assembly, [REP 80.21](#).
2. Remove the tray 4 paper guide, [Figure 1](#).

Figure 1 Paper guide removal

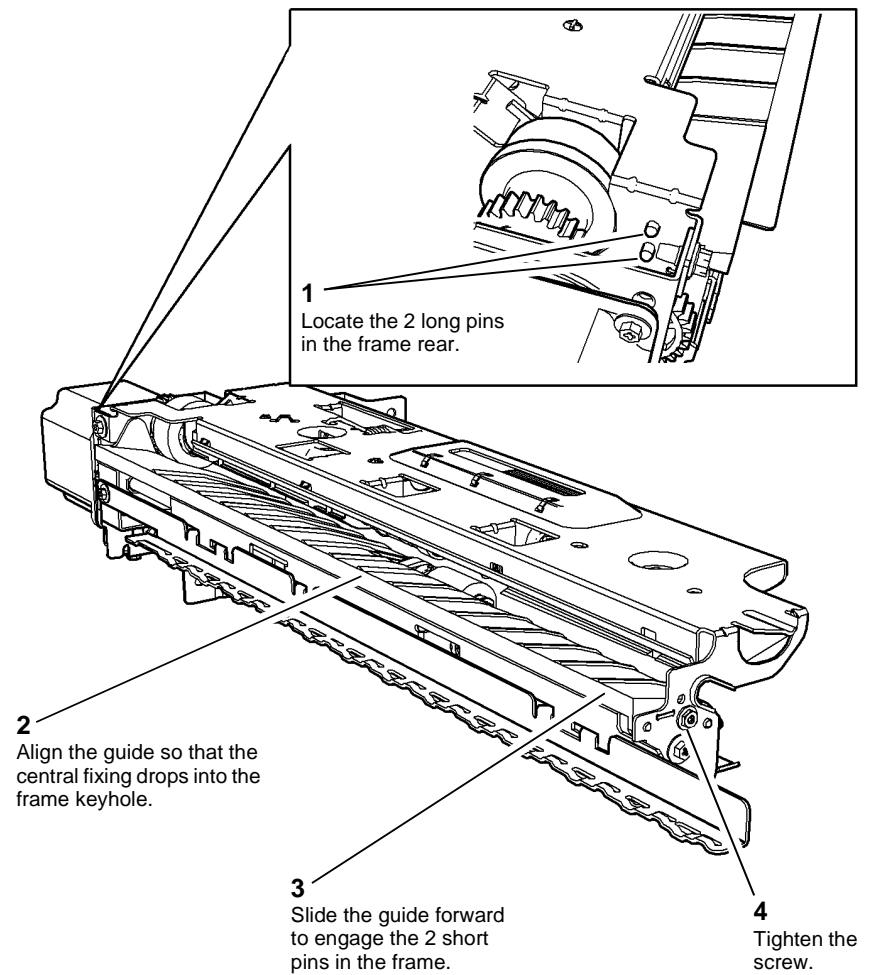
X-1-0753-A

1. Install the tray 4 paper guide, [Figure 2](#).

Figure 2 Paper guide replacement

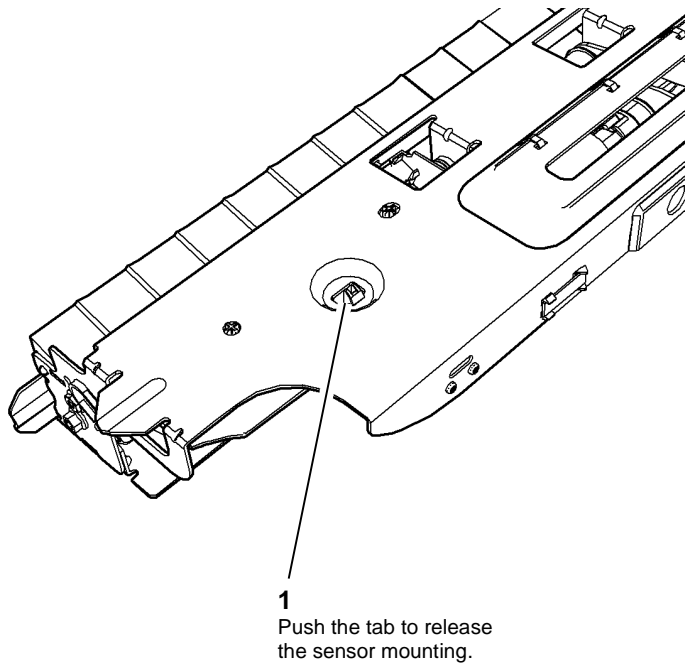
X-1-0739-A

1. Remove the tray 3 paper feed assembly, [REP 80.20](#).
2. Release the sensor mounting, [Figure 1](#).

Figure 1 Sensor mounting release

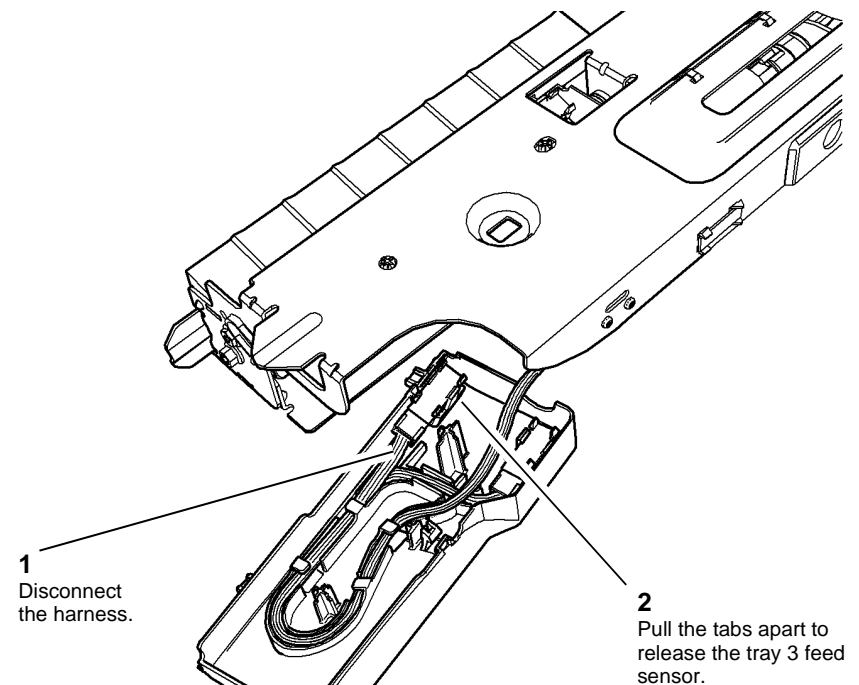
X-1-0740-A

3. Remove the tray 3 feed sensor, [Figure 2](#).

Figure 2 Sensor removal

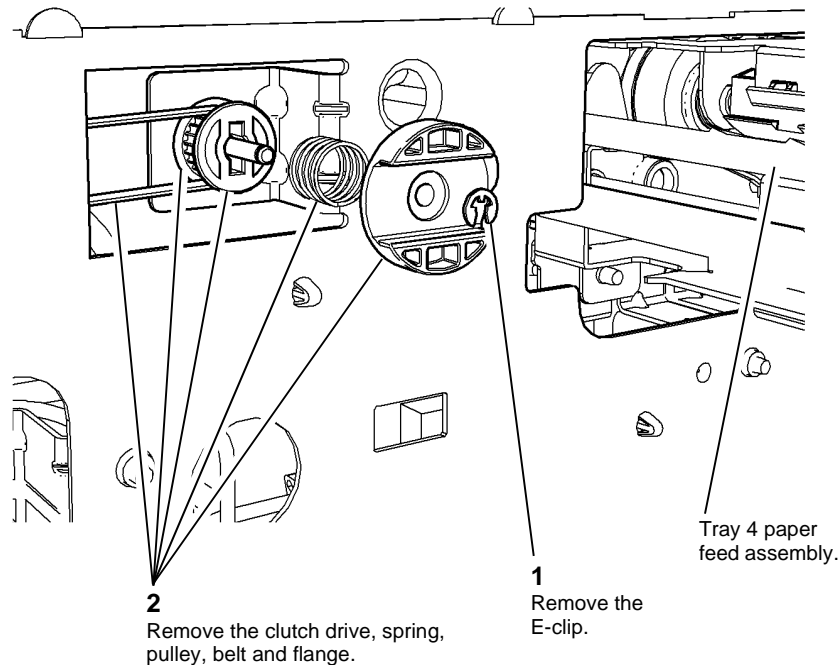
X-1-0756-A

1. Remove tray 1 and 2, [REP 70.1](#).
2. Remove the tray 4 transport assembly, [REP 80.24](#).
3. Remove tray 3 [REP 70.5](#).
4. Remove the tray 4 transport gear pulley, [REP 80.23](#).
5. Remove the tray 4 transport clutch drive assembly, [Figure 1](#).

Figure 1 Clutch drive removal

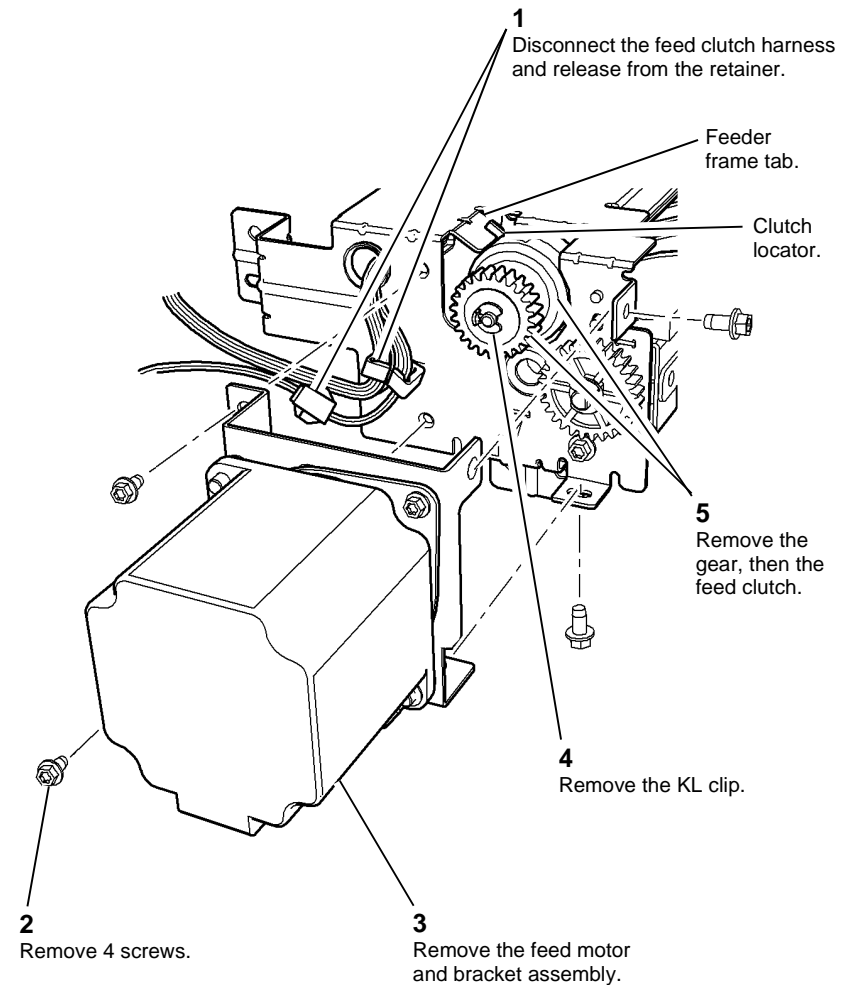
X-1-1425-A

1. Remove the appropriate paper feed assembly:
 - [REP 80.20](#) for tray 3.
 - [REP 80.21](#) for tray 4.
2. Remove the feed clutch, [Figure 1](#).

Figure 1 Feed clutch removal

1. Replacement is the reverse of the removal procedure.
2. Ensure that the clutch locator is engaged with the feeder frame tab, [Figure 1](#).

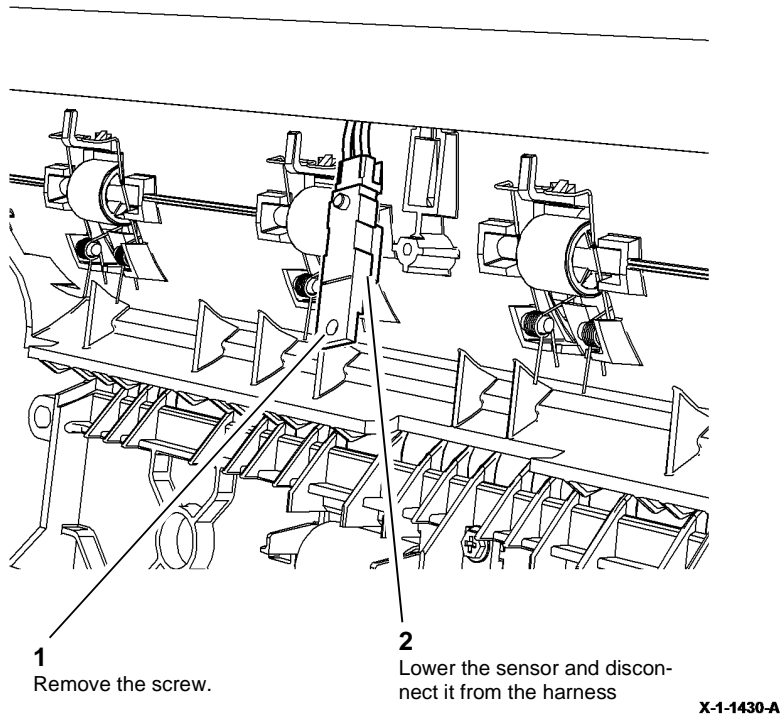
3. Close the left door. Disconnect the harness from the duplex sensor, [Figure 1](#).

Figure 1 Duplex sensor disconnection

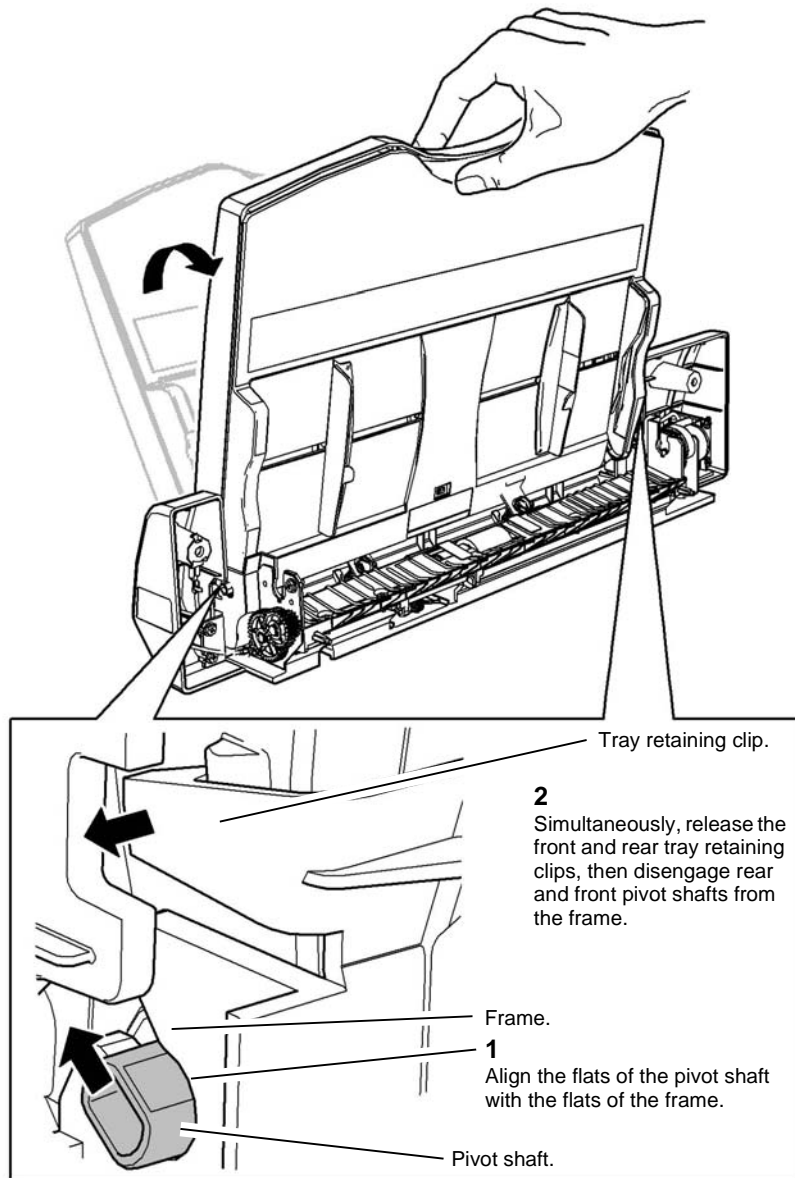
X-1-1462-A

1. Remove the bypass tray assembly, [REP 70.2](#).
2. Release the bypass elevate tray assembly to gain access to the mylar retard shield, [Figure 1](#).

Figure 1 Access the retard shield

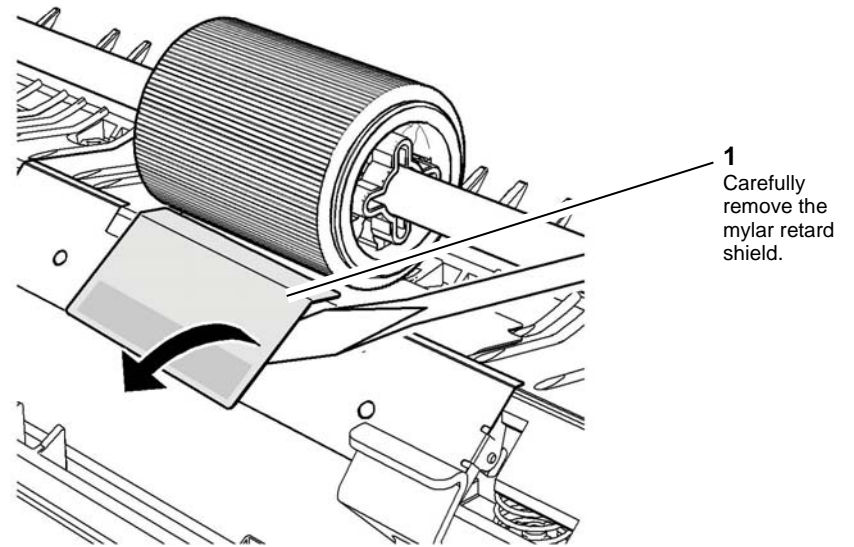
X-1-1463-A

3. Remove the mylar retard shield, [Figure 2](#).

Figure 2 Retard shield removal

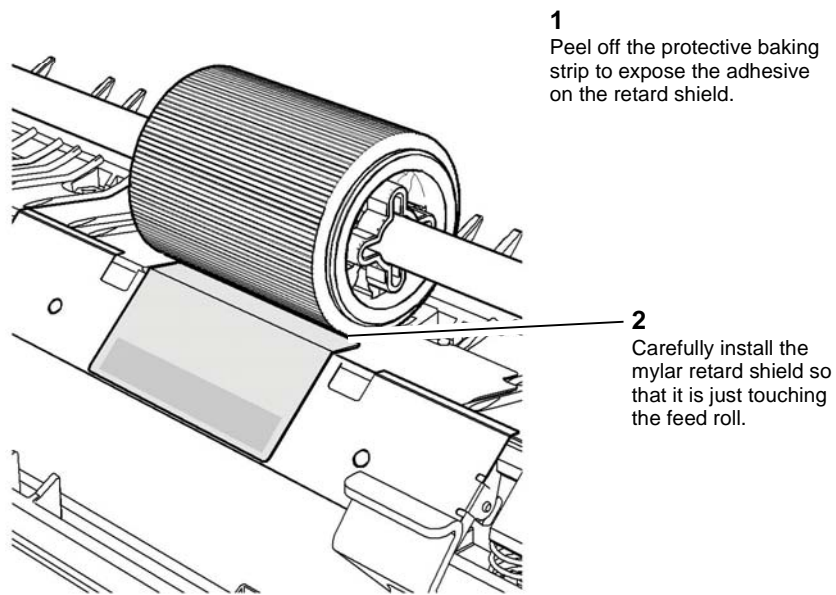
1. Install the mylar retard shield, [Figure 3](#).

Figure 3 Retard shield installation

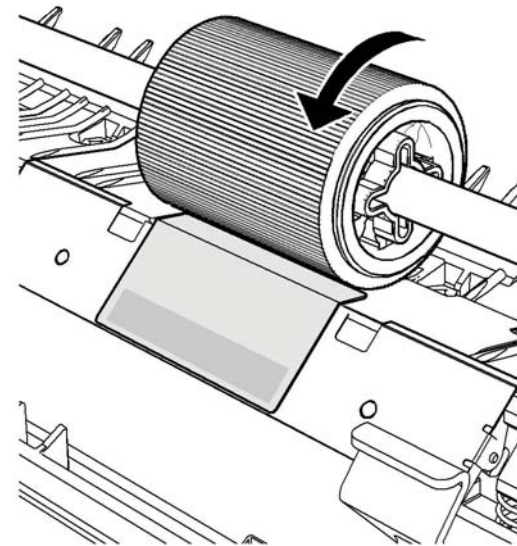
X-1-1465-A

2. Ensure that the mylar retard shield is making contact with the feed roll

Figure 4 Check the contact pressure

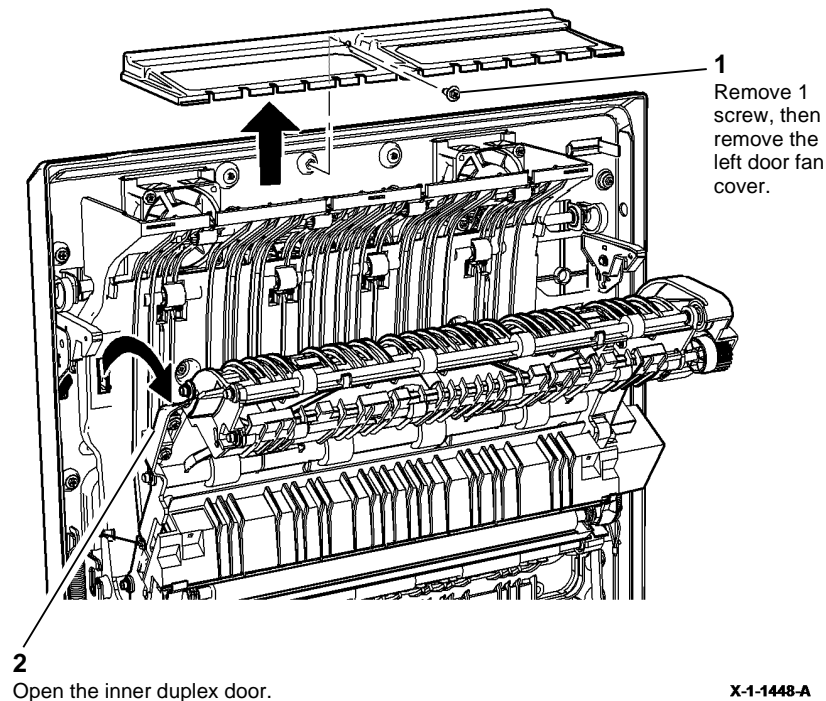
1. Open the left door.
2. [Figure 1](#), prepare to remove the left door fans.

Figure 1 Preparation

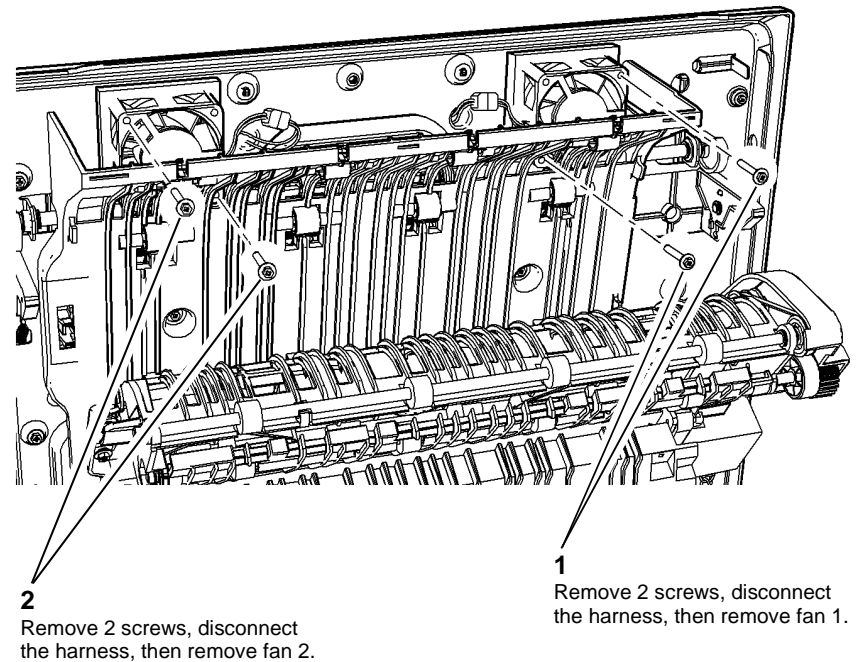
X-1-1449-A

3. [Figure 2](#), remove the left door fans.

Figure 2 Left door fans removal

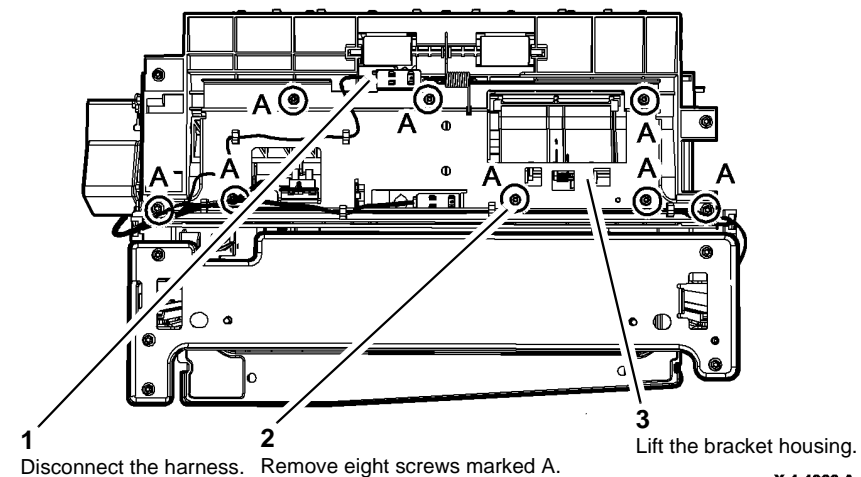
1. Remove the top cover, [PL 75.60 Item 10](#).
2. Prepare to remove the tray 6 feed sensor, [Figure 1](#).

Figure 1 Preparation

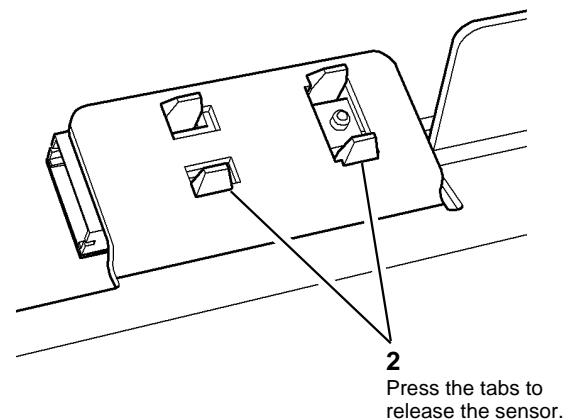
3. Remove the tray 6 feed sensor, [Figure 2](#).

Figure 2 Feed sensor removal

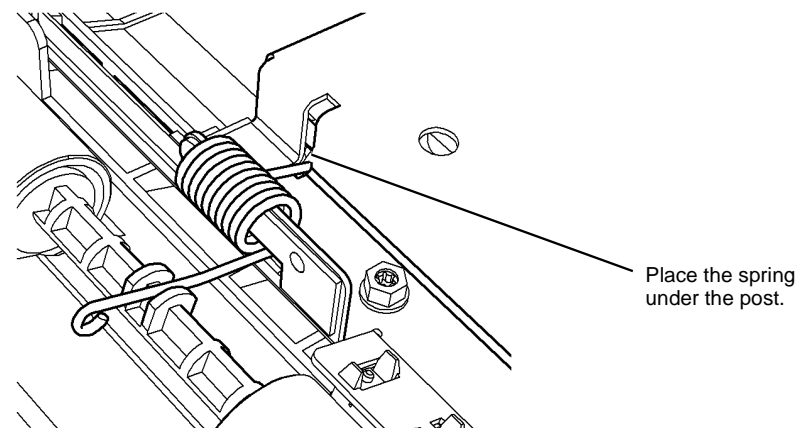
1. The replacement is the reverse of the removal procedure. Refer to [GP 6](#) before refitting the screws.
2. Make sure that the spring on the paper feed assembly is in the correct position, [Figure 3](#).

Figure 3 Spring position

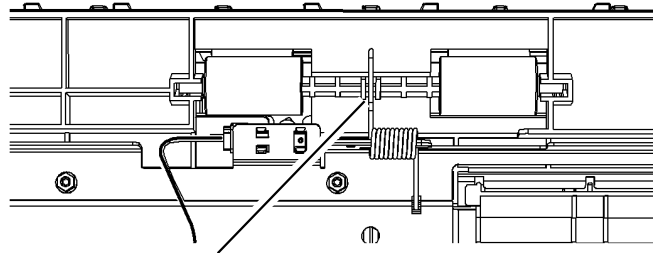
X-1-1969-A

3. Make sure that the spring is positioned on top of the nip roll shaft when the bracket housing is installed, [Figure 4](#).

Spring position.

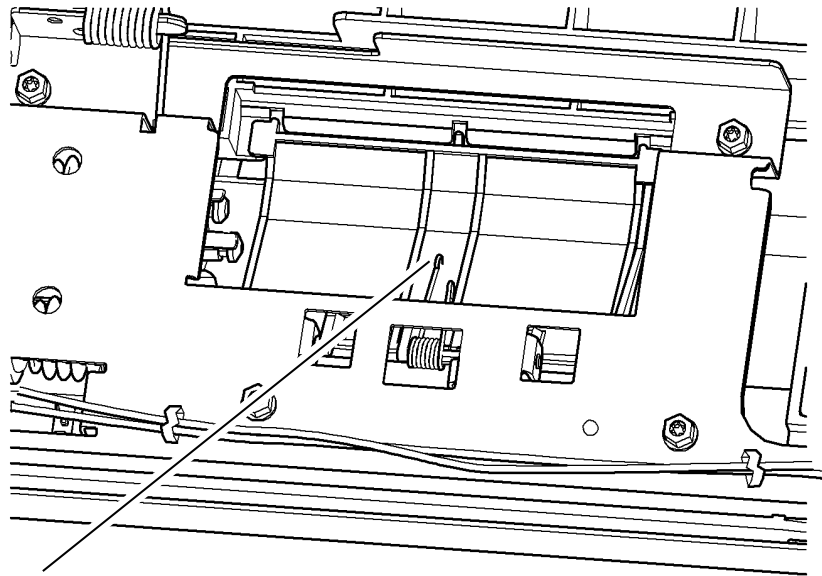
X-1-1970-A

4. Make sure that the spring is positioned on top of the chute upper insert, [Figure 5](#).

Position the spring on the top of the chute upper insert.

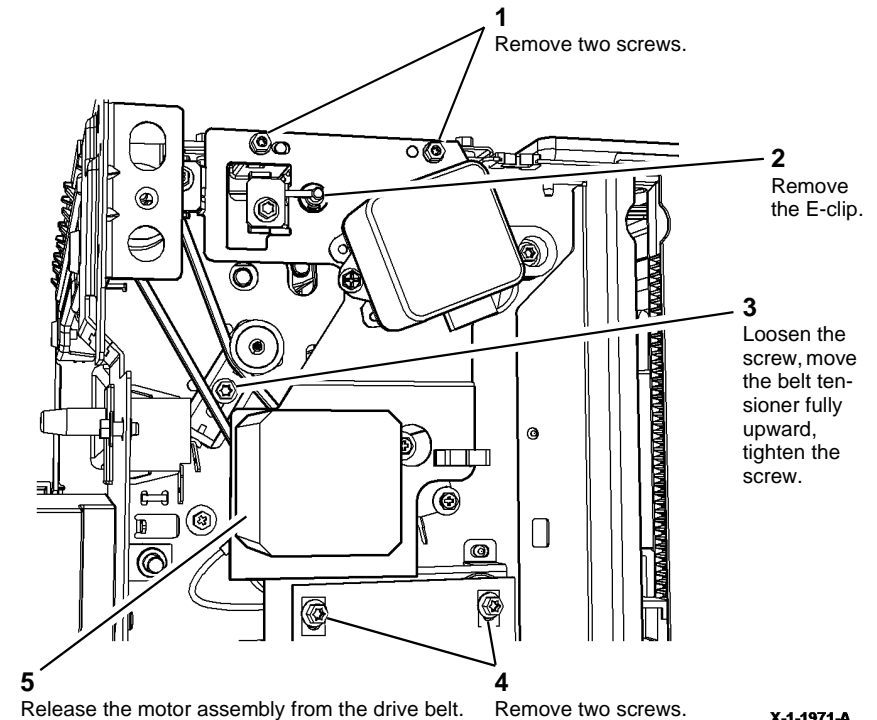
Figure 1 Preparation

1. Remove the rear cover, [PL 75.60](#) Item 9.
2. Prepare to remove the drive belt, [Figure 1](#).

1. Replacement is the reverse of the removal procedure. Refer to [GP 6](#) before refitting the screws.
2. Allow the tension idler to tension the belt and then tighten the screw, [Figure 1](#).

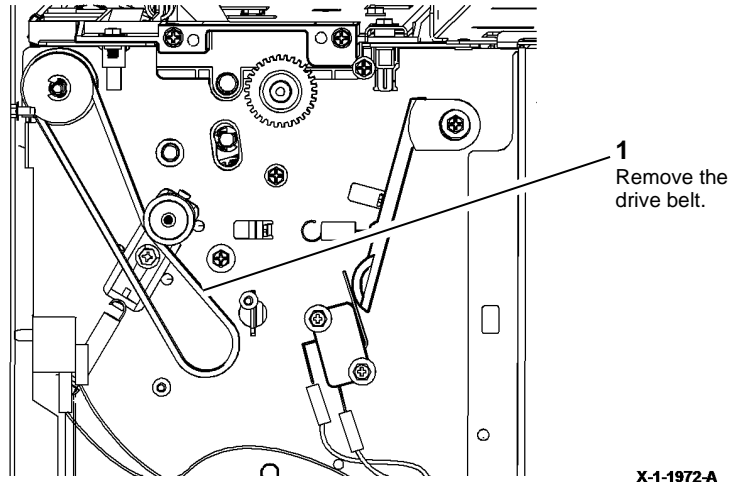
Figure 2 Drive belt removal

3. Remove the transport drive belt, [Figure 2](#).

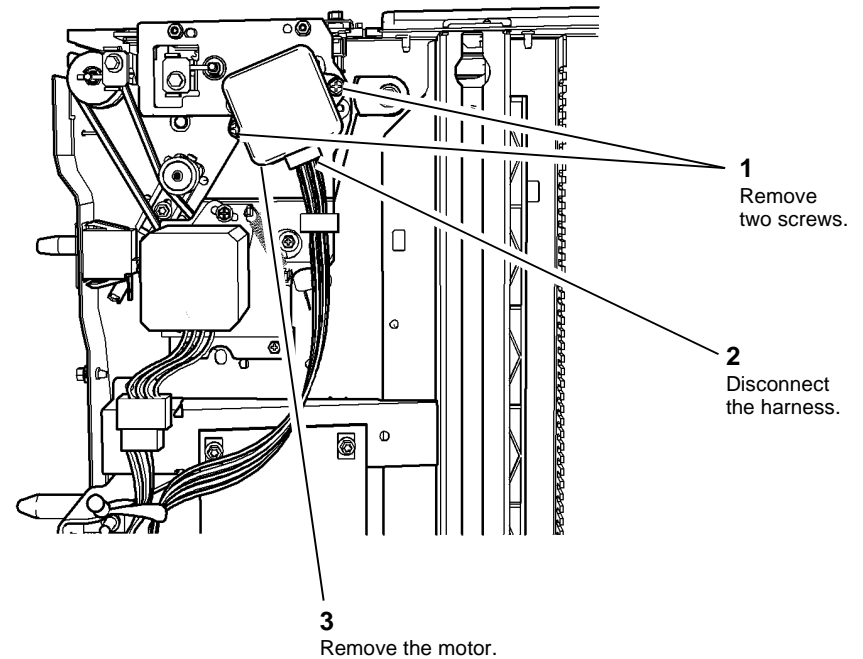
Figure 1 Feed motor removal

1. Remove the rear cover, [PL 75.60 Item 9](#).
2. Remove tray 6 feed motor, [Figure 1](#).
