708P91368
September 2017

Xerox® AltaLink® B8090 Family Multifunction Printer Service Manual

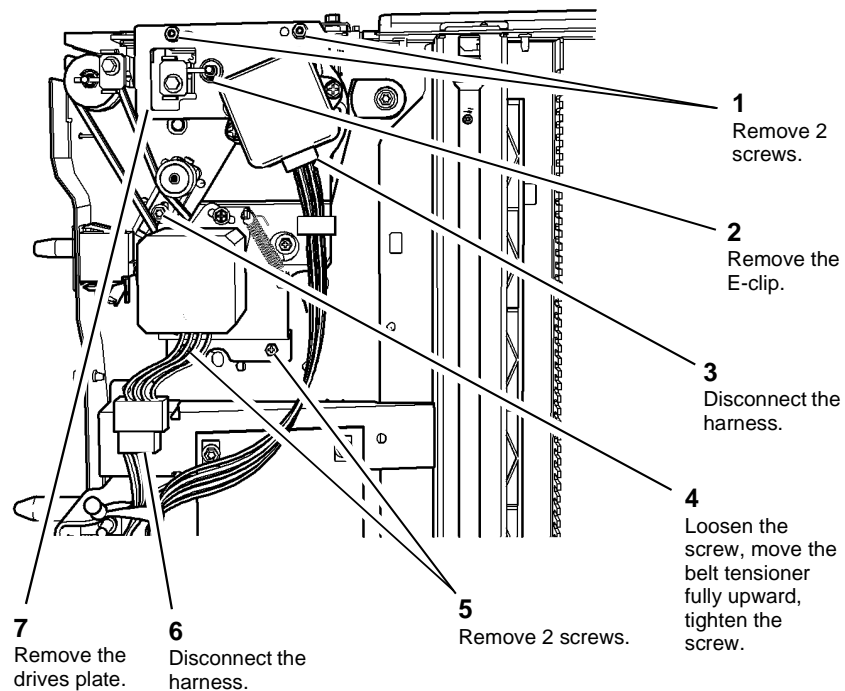
Figure 1 Drives plate removal

1. Remove the rear cover, [PL 75.60](#) Item 9.
2. Remove the drives plate, [Figure 1](#).

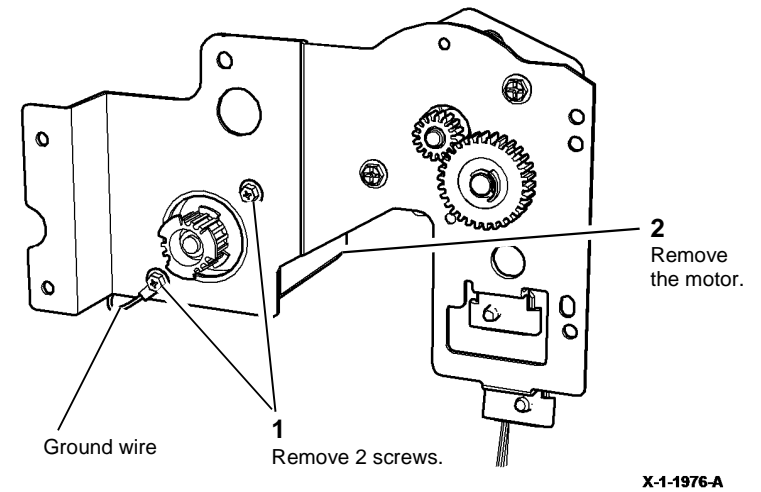
Figure 2 Transport motor removal

3. Remove the tray 6 transport motor, [Figure 2](#).

1. The replacement is the reverse of the removal procedure. Refer to [GP 6](#) before refitting the screws.
2. Ensure that the ground wire terminal is located under the motor securing screw, [Figure 2](#).

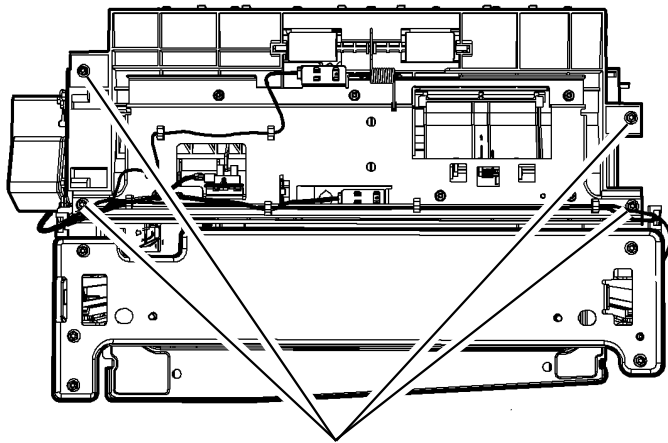
X-1-1977-A

1. Remove the rear cover, [PL 75.60 Item 9](#).
2. Remove the top cover, [PL 75.60 Item 10](#).
3. Remove the tray 6 transport drive belt, [REP 80.37](#).
4. Prepare to remove the lower feed assembly, [Figure 1](#).

- 1 Remove four screws.

1. The replacement is the reverse of the removal procedure. Refer to [GP 6](#) before refitting the screws.
2. Check that the cable routing is correct, [Figure 1](#).
3. Perform [ADJ 70.5](#) Tray 6 Stack Height Sensor and Retard Shield.

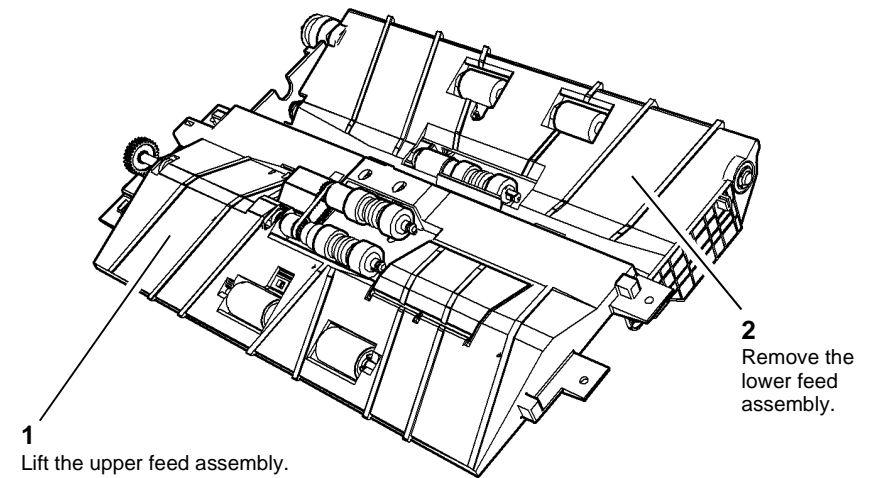
Figure 2 Lower feed removal

6. Remove the lower feed assembly, [Figure 2](#).

- 1 Lift the upper feed assembly.

- 2 Remove the lower feed assembly.

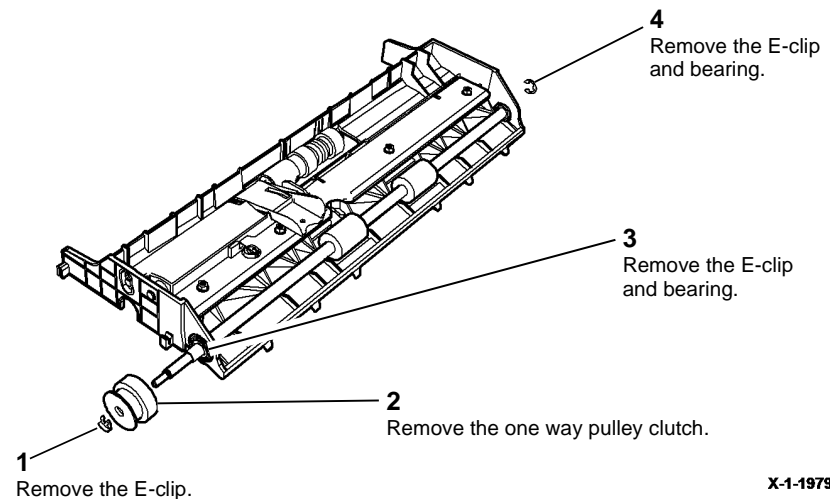
Figure 3 Components removal

7. Remove components, [Figure 3](#).

- 1 Remove the E-clip.

- 2 Remove the one way pulley clutch.

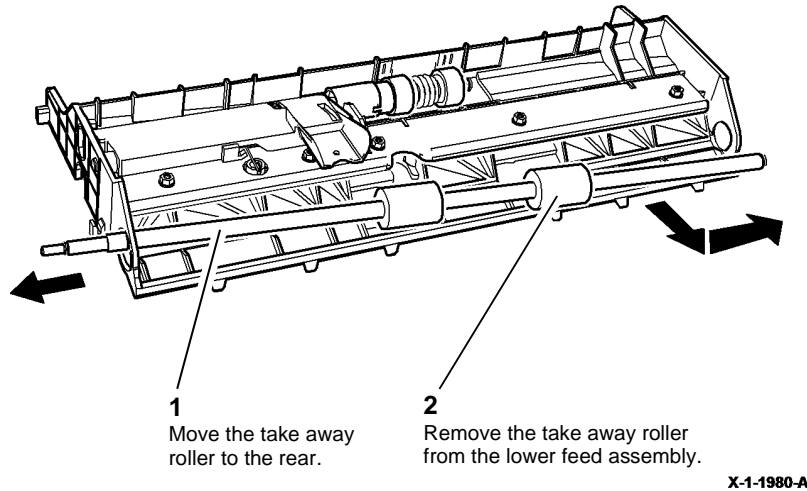
8. Remove the takeaway roller, [Figure 4](#).

1 Move the take away roller to the rear.

2 Remove the take away roller from the lower feed assembly.

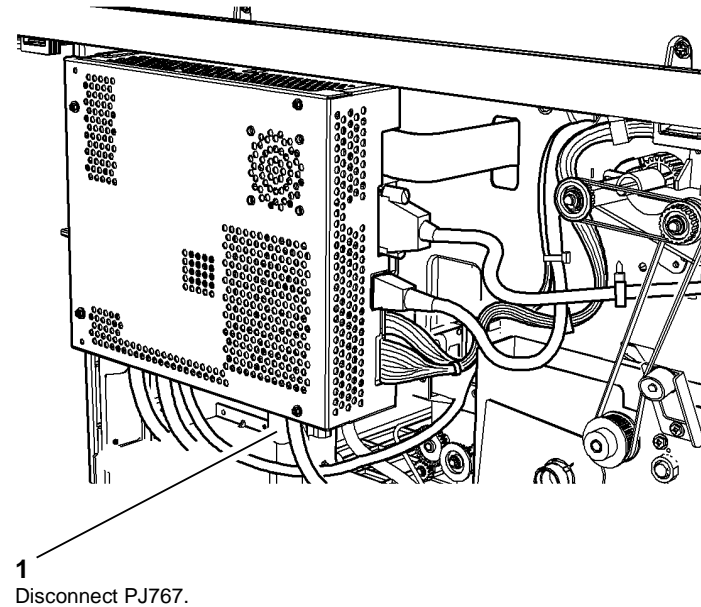
Figure 1 PJ850 disconnection

1. Remove the toner cartridge, [PL 90.17 Item 2](#).
2. Remove the print cartridge, [PL 90.17 Item 9](#), then place it in a lightproof bag.
3. Remove the rear cover, [REP 28.2](#).
4. Remove the relevant component:
 - Centre output tray, [REP 10.9](#).
 - Horizontal transport, [REP 10.6](#).
5. Remove the inner machine cover, [PL 28.10 Item 12](#).
6. Disconnect PJ850 from the [SBC PWB](#), [Figure 1](#).

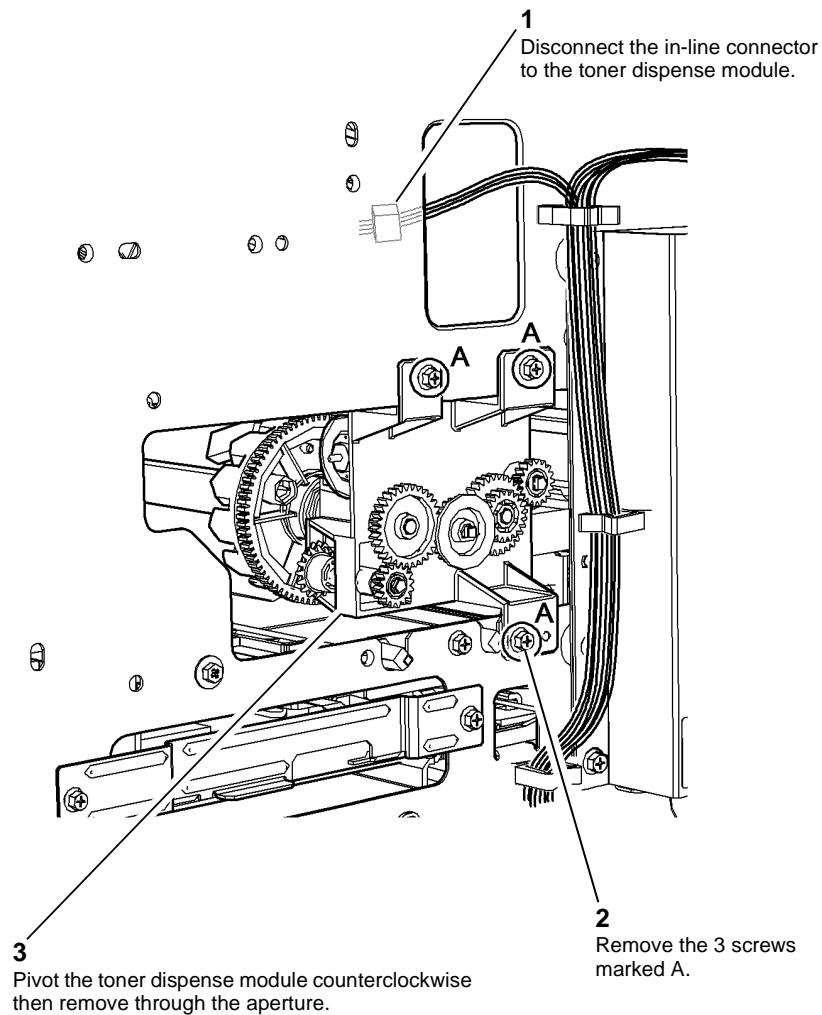
Figure 2 Module removal

- Remove the toner dispense module, [Figure 2](#).

NOTE: For clarity, the single board controller module is not shown in [Figure 2](#).

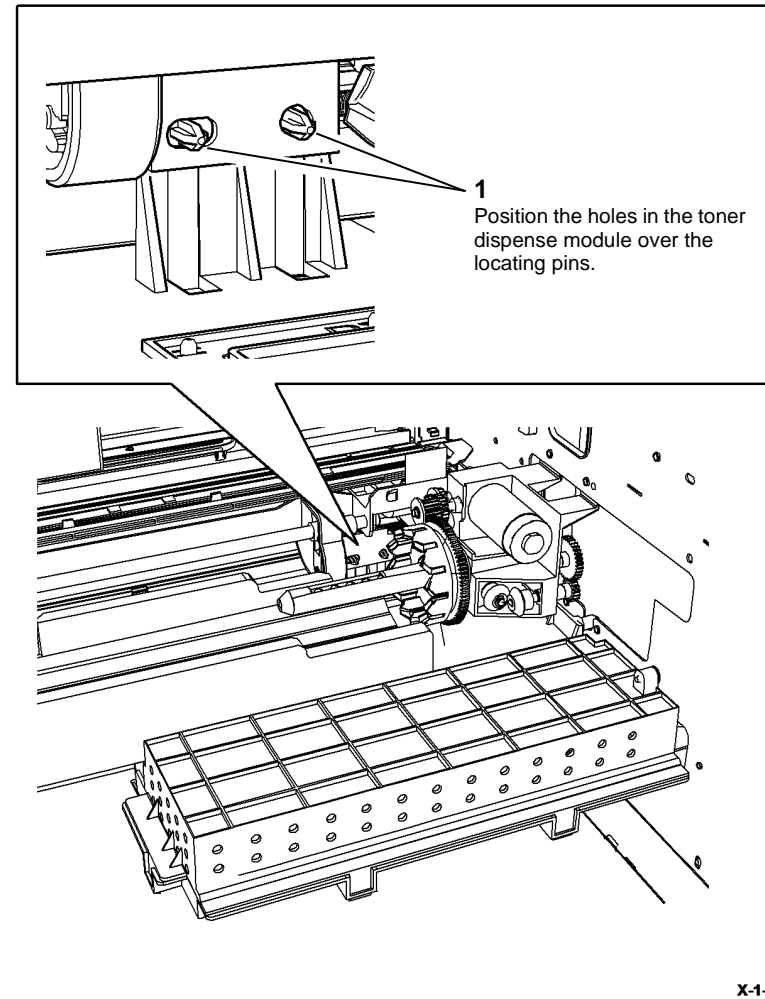
Figure 3 Installation

- The replacement is the reverse of the removal procedure.
- When installing the toner dispense module, ensure the locating pins on the HVPS tray assembly are inserted in the holes in the toner dispense module, [Figure 3](#).

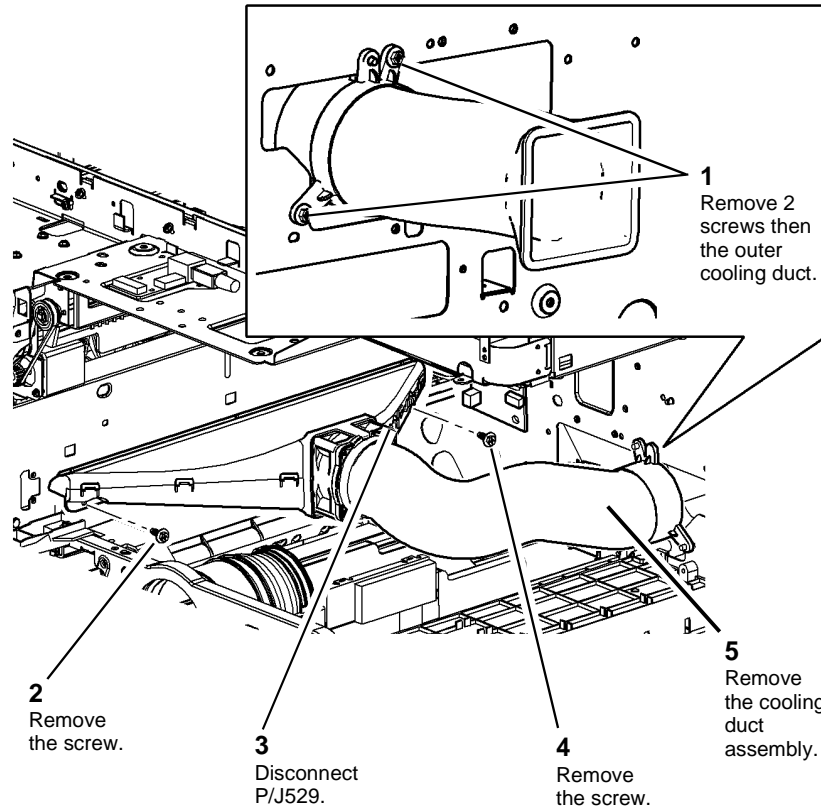
Figure 1 Cooling duct removal

7. Remove the print cartridge cooling duct assembly, [Figure 1](#).

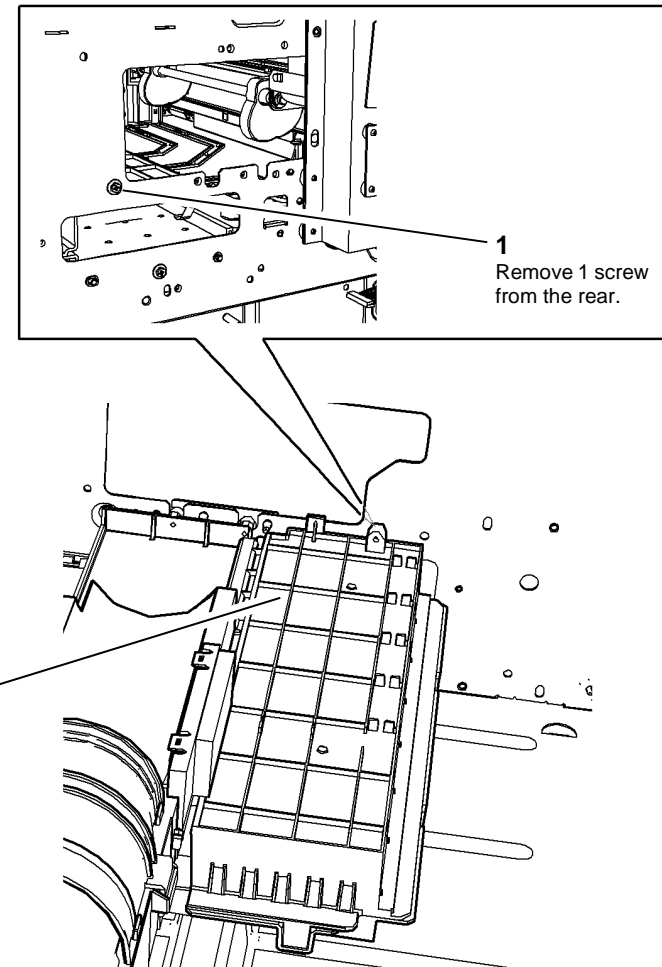
Figure 2 HVPS top cover removal

8. Remove the HVPS top cover, [Figure 2](#).

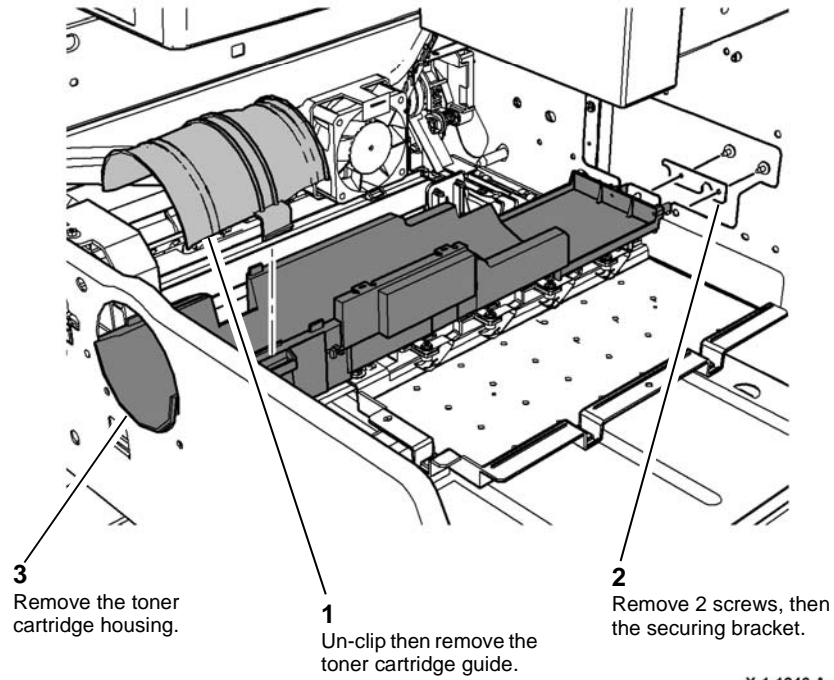
Figure 3 Toner cartridge removal

9. Remove the toner cartridge housing, [Figure 3](#).

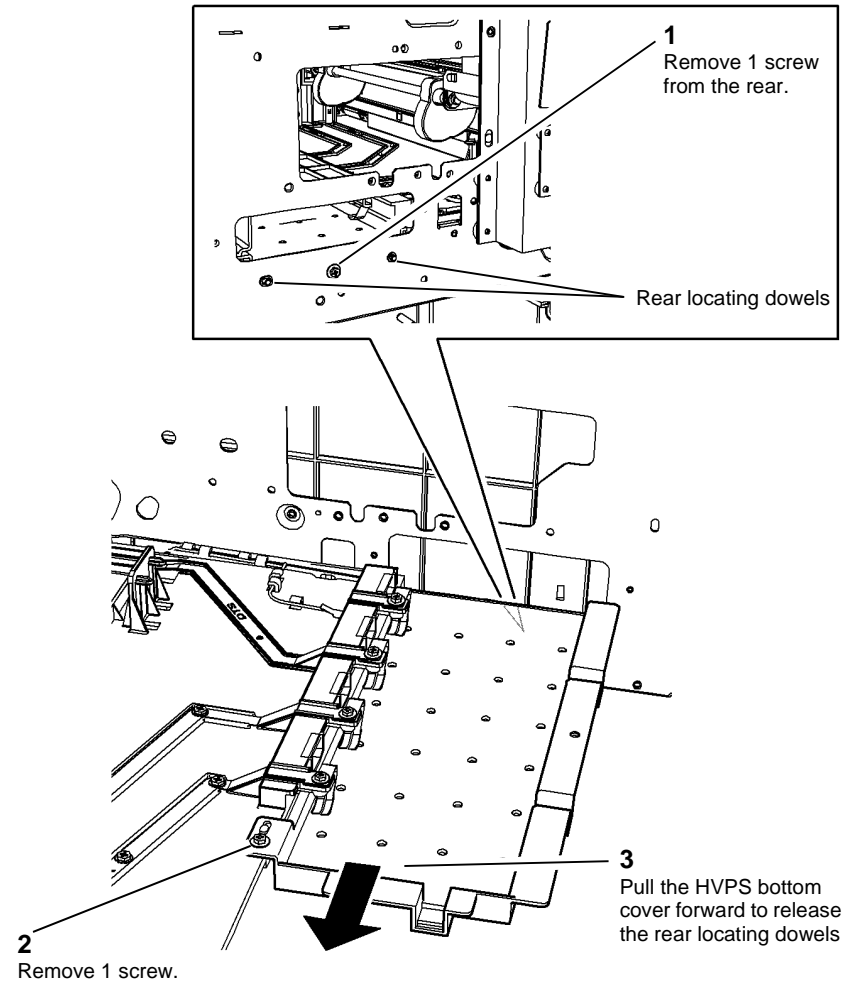
Figure 4 Preparation

10. Prepare to remove the HVPS tray assembly, [Figure 4](#).

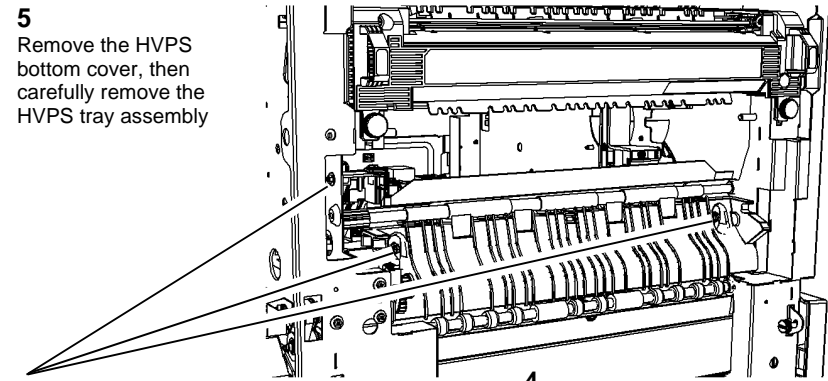
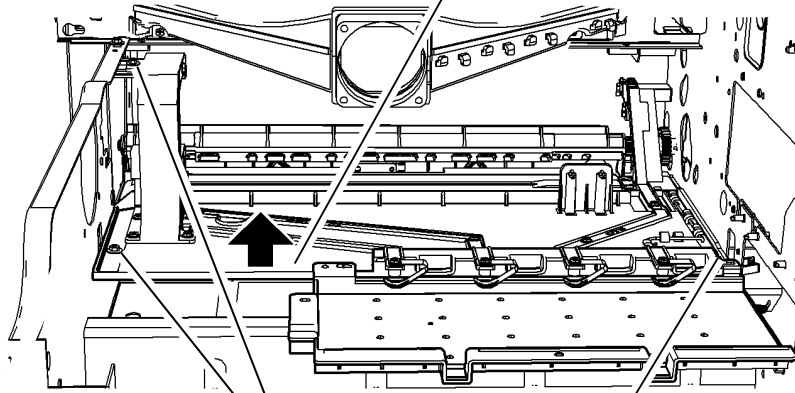
11. Remove HVPS bottom cover and the HVPS tray assembly, [Figure 5](#).

5
Remove the HVPS bottom cover, then carefully remove the HVPS tray assembly

1
Remove 2 screws from the left side and 1 screw from the rear.

4
Raise the right side of the tray to release the HVPS bottom cover.

2
Remove the 2 front screws.

3
Remove the rear screw.

3. Install the 6 screws removed in [Figure 5](#).
4. Reverse the removal procedure to install the remaining components.

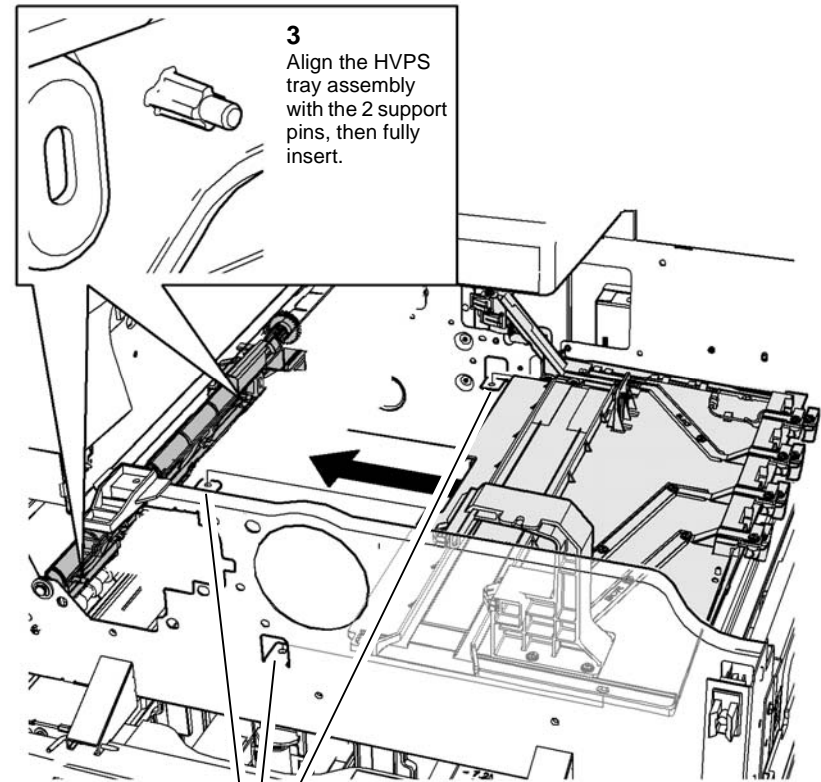
1. Install the HVPS tray assembly, [Figure 6](#).

NOTE: For clarity, the print cartridge fan duct is not shown in [Figure 6](#).

1
Carefully position the HVPS tray assembly in the machine cavity.

2
Move the HVPS tray assembly to the left. Ensure that the HVPS tray assembly is positioned above the tray support lugs.

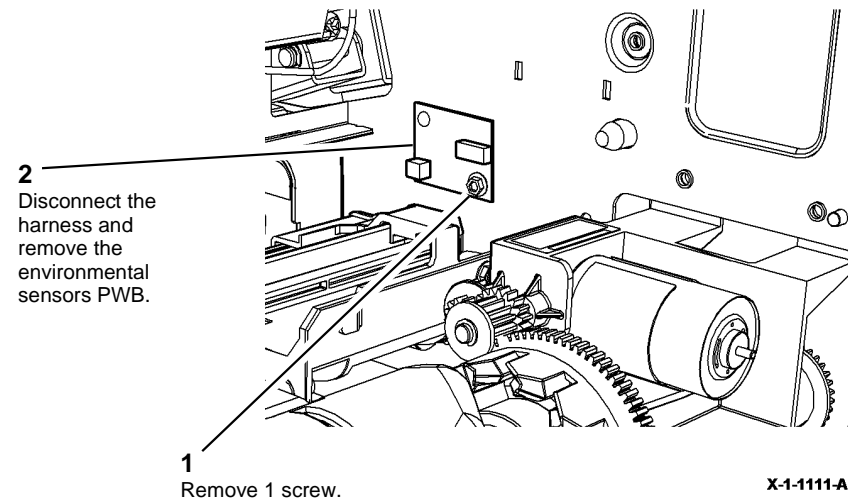
Figure 1 Removal

1. Remove the relevant component:
 - Centre output tray, [REP 10.9](#).
 - Horizontal transport, [REP 10.6](#).
2. Remove the inner machine cover, [PL 28.10 Item 12](#).
3. Remove the environmental sensors PWB, [Figure 1](#).

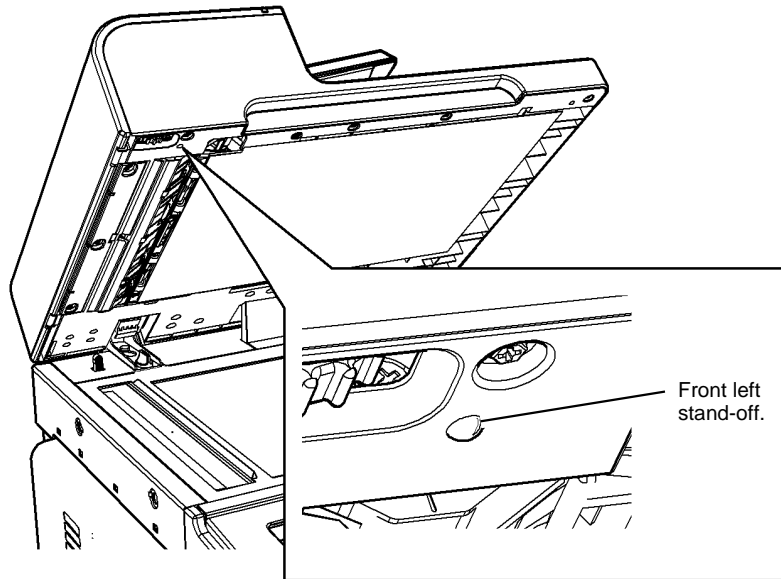
Figure 1 Front left stand-off location

1. Check the gap between the front left stand-off, [Figure 1](#), and the top cover assembly, [PL 60.15 Item 2](#).

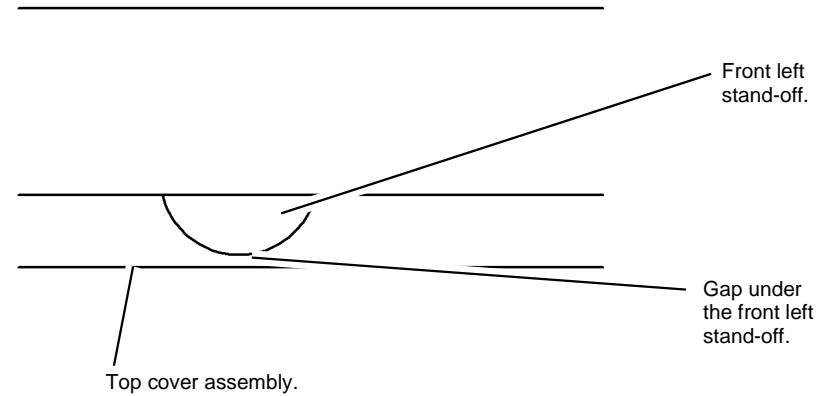
Figure 2 Front left stand-off gap

3. View the front left stand-off gap, [Figure 2](#), in the space between the SPDH and the scanner module. The front left stand-off must just touch the top cover assembly.

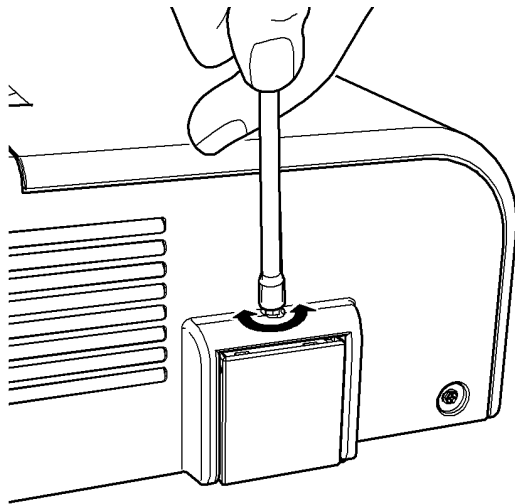
Figure 3 Left side adjustment

NOTE: If the rear of the SPDH is lowered too far then it will start to lift the front off the document glass frame.

NOTE: If the front of the SPDH is lowered too far then it will start to lift the rear of the SPDH.

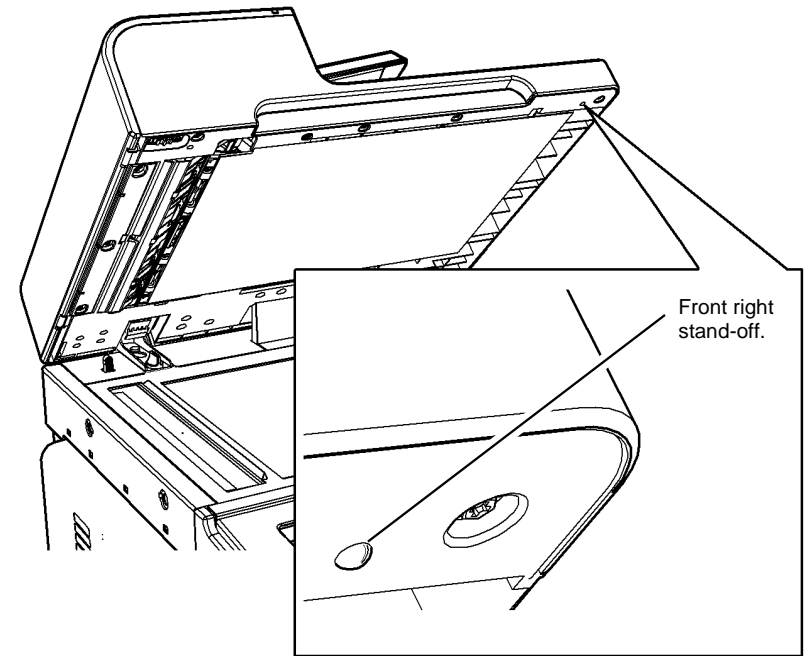
Figure 4 Front right stand-off location

1. Check the gap between the front right stand-off, [Figure 4](#), and the top cover assembly.

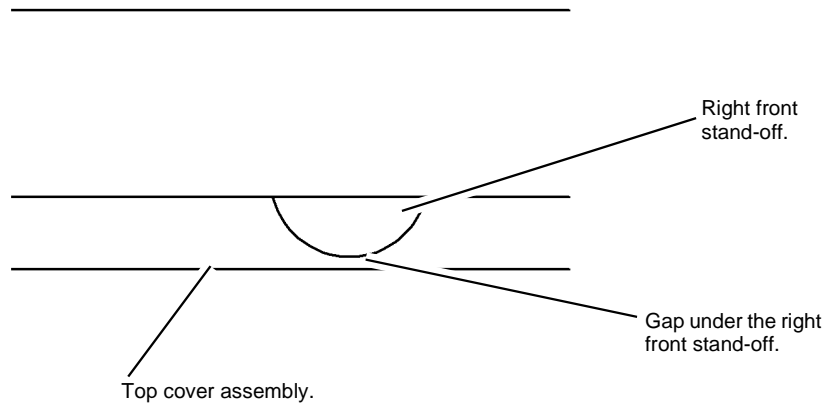
Figure 5 Front right stand-off gap

- View the front right stand-off gap, [Figure 5](#), in the space between the SPDH and the scanner module. The front right stand-off must just touch the top cover assembly

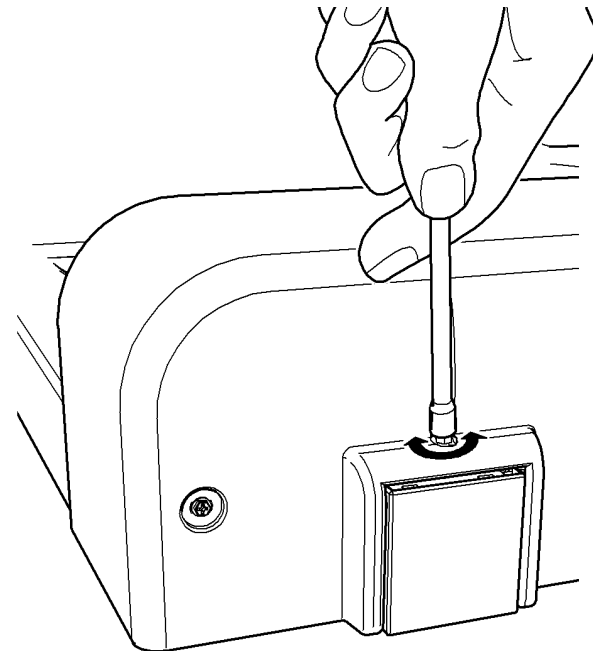
- [Figure 6](#), adjust the right counterbalance.

NOTE: It should only be necessary to adjust the height by approximately 1 turn of the adjustment screw. Observe the stand-off whilst adjusting the screw. Stop when the front right stand-off is in contact with the top cover assembly.

Turn the screw counterclockwise to raise the front of the SPDH.

Turn the screw clockwise to lower the front of the SPDH.

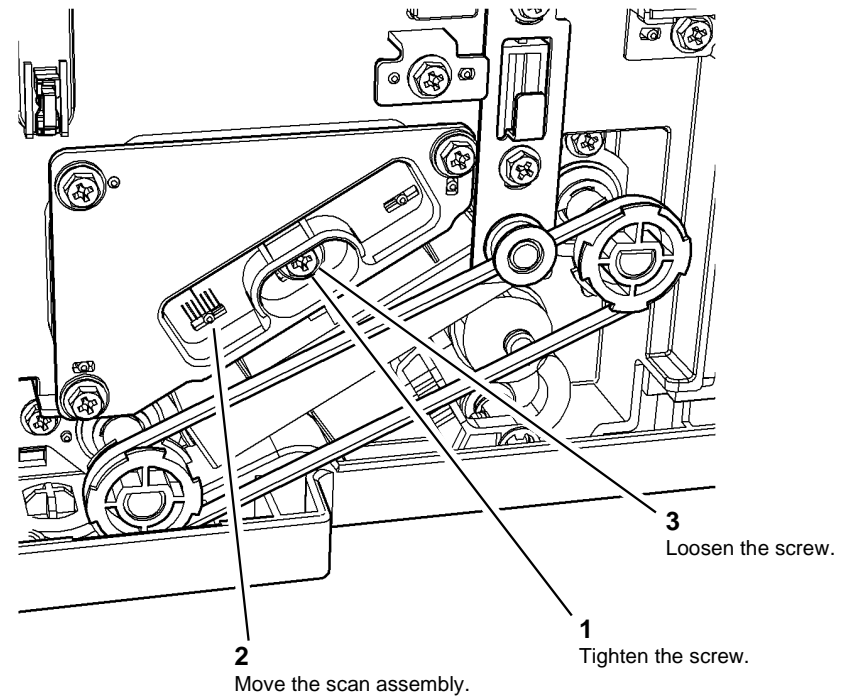
Figure 1 Adjusting the scan assembly position

NOTE: The notes that follow apply to the adjustment:

- One graduation of the scale will move the skew by 0.6mm on a A4 LEF sheet (0.024 inch on a 8.5 x 11 inch LEF sheet).
- If the indicator is moved upward on the scale, the image will be rotated clockwise.
- If the indicator is moved downward on the scale, the image will be rotated counter-clockwise.

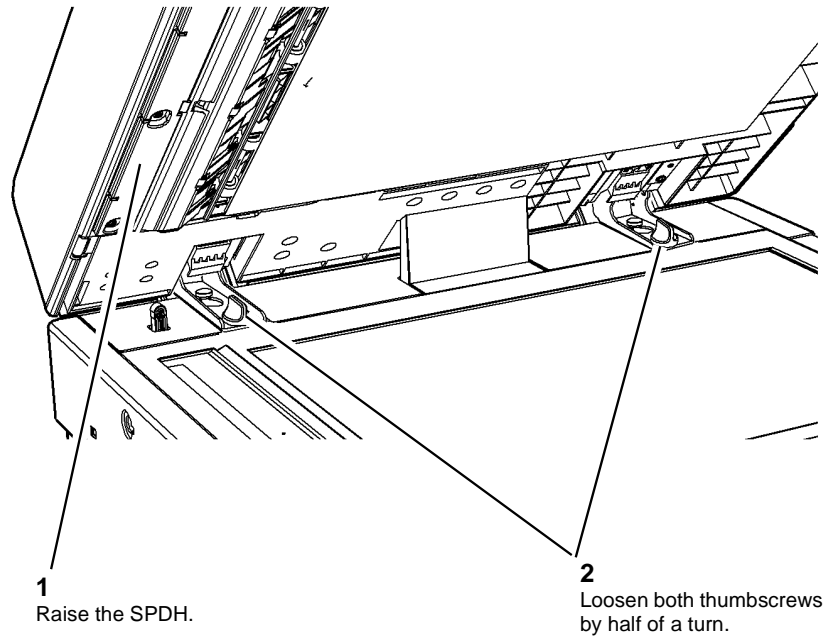
Figure 2 Preparation

1. Prepare to adjust the side 1 skew, [Figure 2](#).

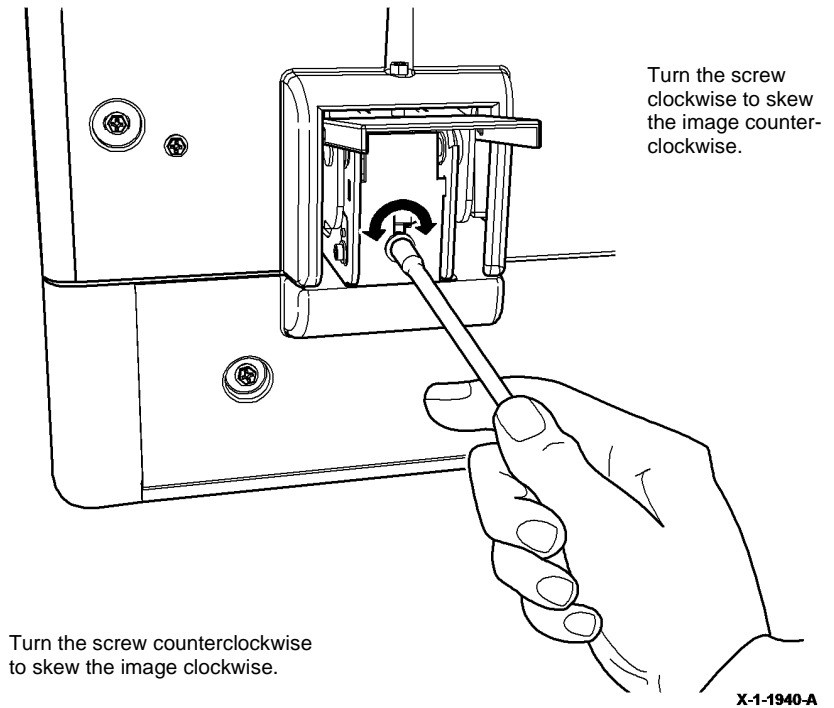
Figure 3 Side 1 skew adjustment

2. Adjust the side 1 skew, [Figure 3](#).

NOTE: Approximately 3 turns of the adjustment screw will move the skew by 1mm on a A4 LEF sheet (0.04 inch on a 8.5 x 11 inch LEF sheet).

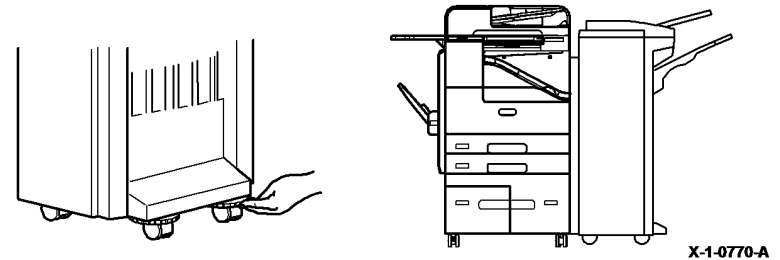
Figure 1 Machine to 2K LCSS alignment

Turn the hand wheels above the castors below bin 1 to adjust the alignment:

- Turn both hand wheels in the same direction to adjust the vertical alignment between the 2K LCSS and the machine. The 2K LCSS should be in vertical alignment with the machine, viewed from the front and rear, [Figure 1](#).

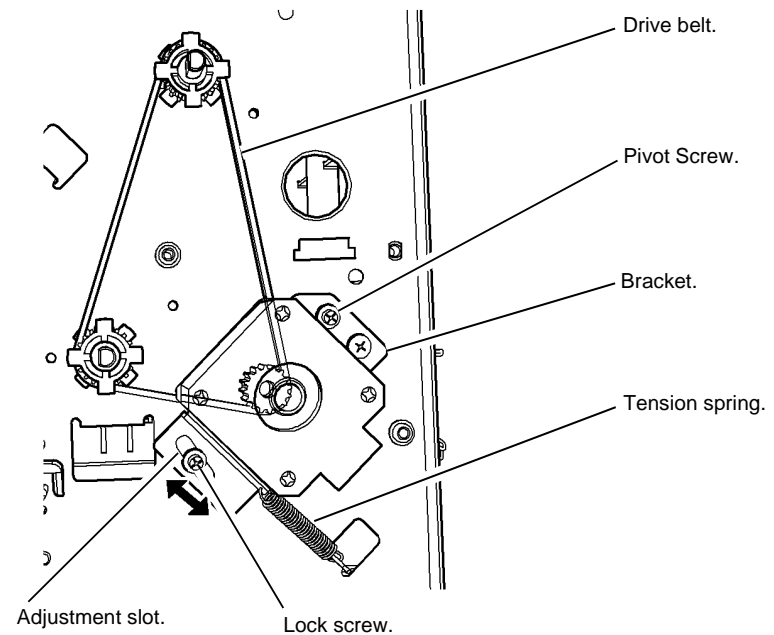
1. Figure 1 shows a typical arrangement. Press the belt midway between pulleys and check that the bracket moves to stretch the spring. Slacken the bracket screws if necessary. Allow the spring to pull the bracket and tension the drive belt, then tighten the bracket screws.

NOTE: Check the belt condition and routing if the tension spring is not extended, or the locking screw is at the end of the bracket adjustment slot.

Typical belt tensioning arrangement.

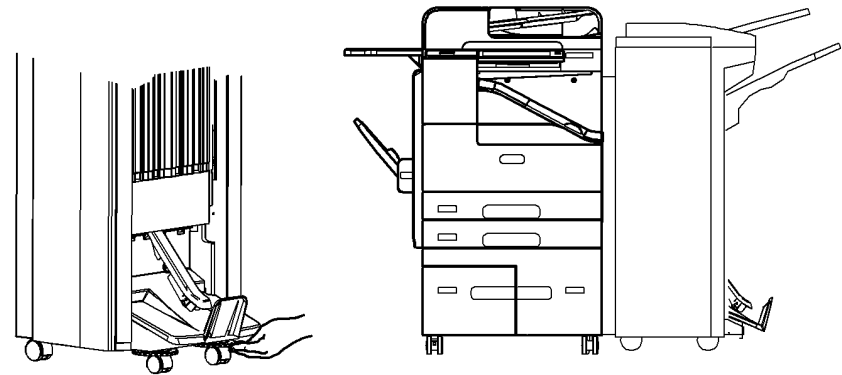
Figure 1 Machine to LVF BM alignment

1. [Figure 1](#), turn both right hand wheels in the same direction to adjust the vertical alignment between the LVF BM and the machine viewed from the front or rear.

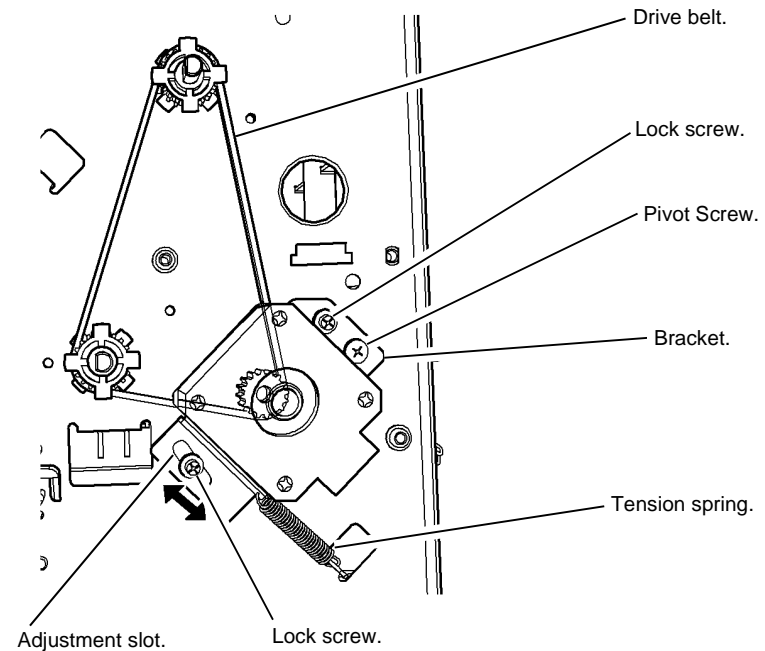
1. Figure 1 shows a typical arrangement. Slacken the bracket lock screws. Press the belt midway between pulleys and check that the bracket moves and returns by the spring pull.
2. Release the belt and allow the spring to pull the bracket and tension the drive belt then tighten the lock screws.

NOTE: Check the belt condition and routing if the tension spring is not extended or the locking screw is at the end of the bracket adjustment slot.

Typical belt tensioning arrangement.

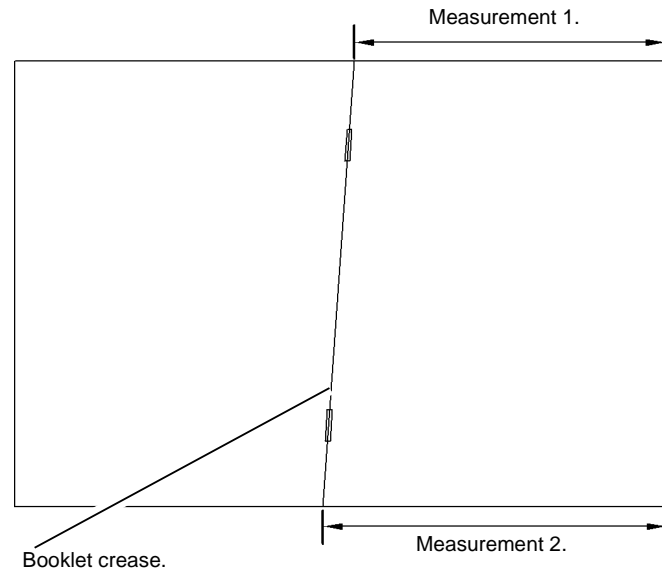
Figure 1 Booklet skew

1. Run a copy job of 3 stapled 4 sheet booklets.
2. Open out the booklet at the centre page and press it onto a flat surface. Measure the misalignment of the open side edges of the booklet, [Figure 1](#).

The amount of skew is the difference between the two measurements.

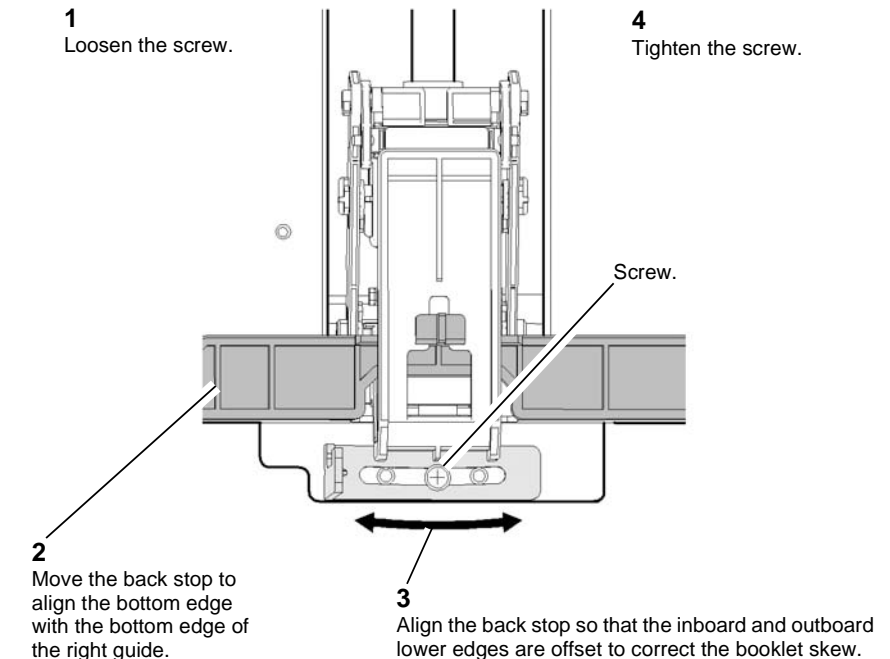
Figure 2 Back stop adjustment

1. Perform [REP 12.19-150](#) steps 1 to 7 to uncover the back stop right guide assembly.
2. [Figure 2](#), adjust the position of the back stop.

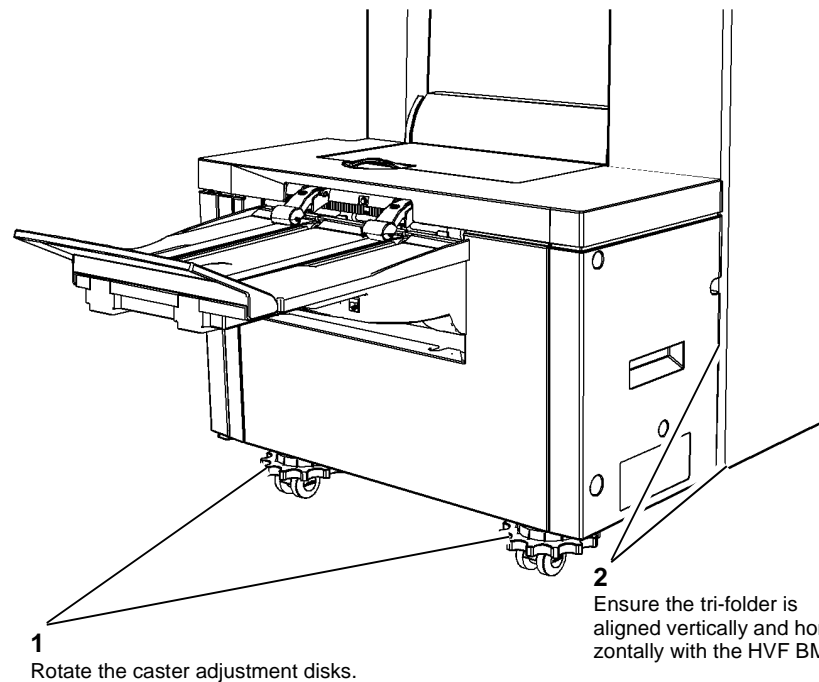
X-1-0779-A

Figure 2 Tri-folder to HVF BM alignment

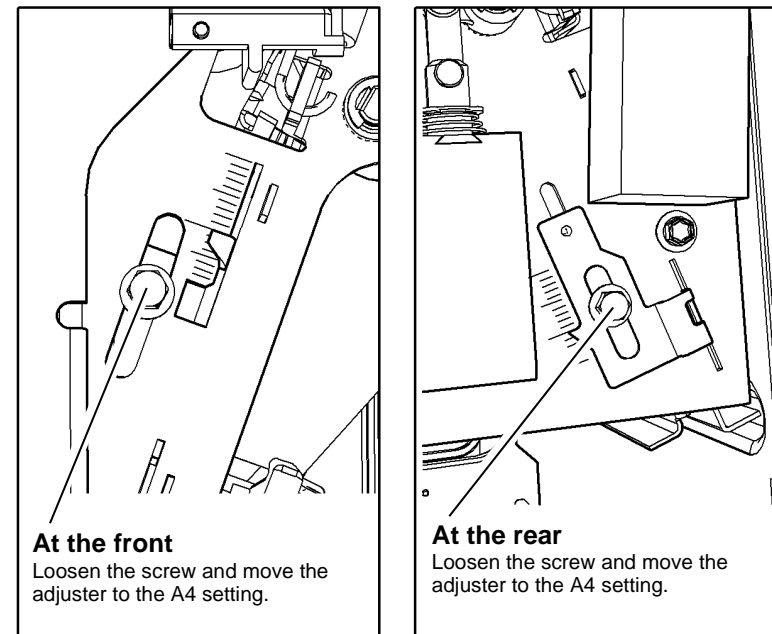
X-1-0780-A

Figure 1 A4 paper setting

1. Remove the front door, [PL 12.200 Item 2](#).
2. Remove the front cover, [PL 12.200 Item 12](#).
3. Remove the rear cover, [PL 12.200 Item 3](#).
4. Set the folder to the appropriate paper size:
 - To set the folder for A4 paper, [Figure 1](#).
 - To set the folder for 8.5 x 11 inch paper, [Figure 2](#).

NOTE: Do not over loosen the adjuster screws. The adjusters can detach from the backstop. Make sure the position of the backstop changes when the adjusters are moved.

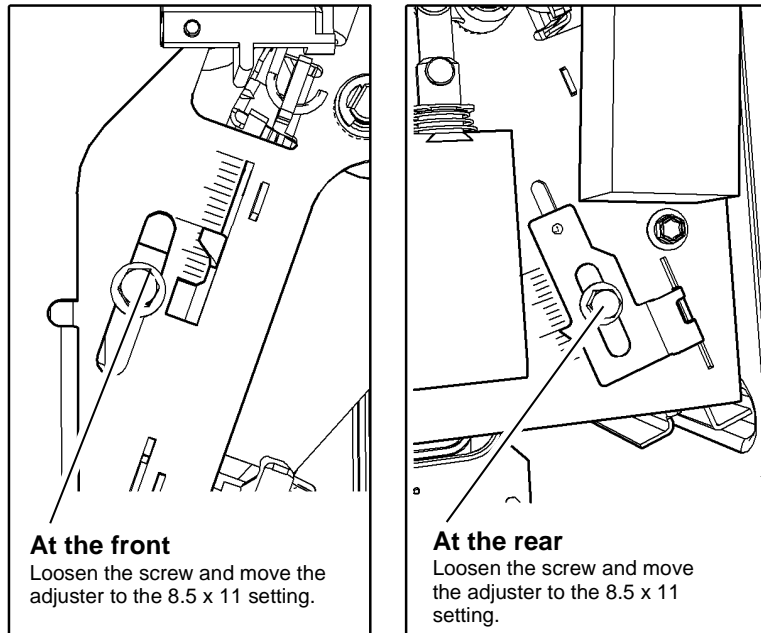
X-1-0781-A

Figure 2 8.5 x 11 inch paper setting

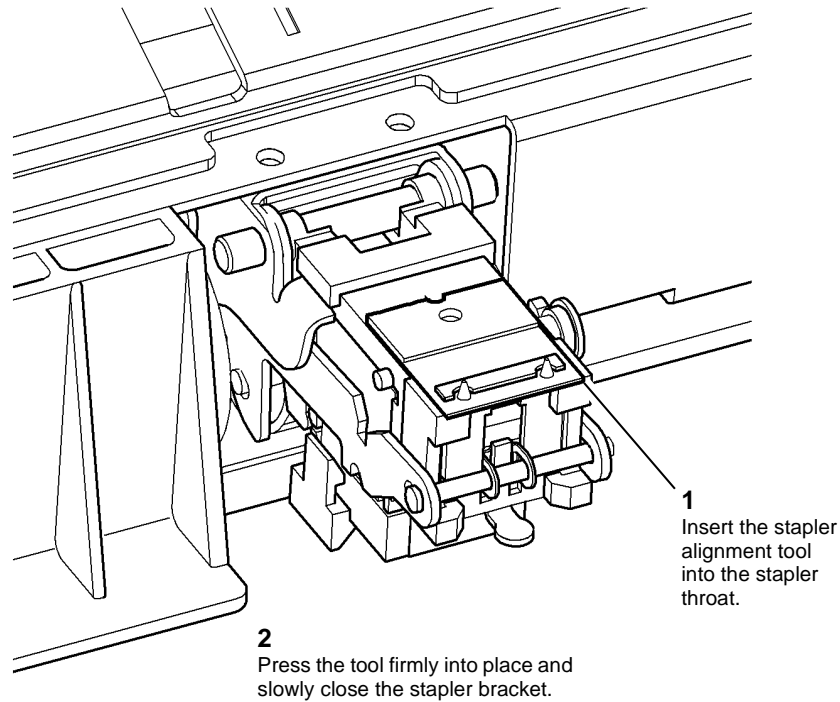
X-1-0782-A

3. **Figure 1**, insert the alignment tool.

Figure 1 Alignment tool insertion

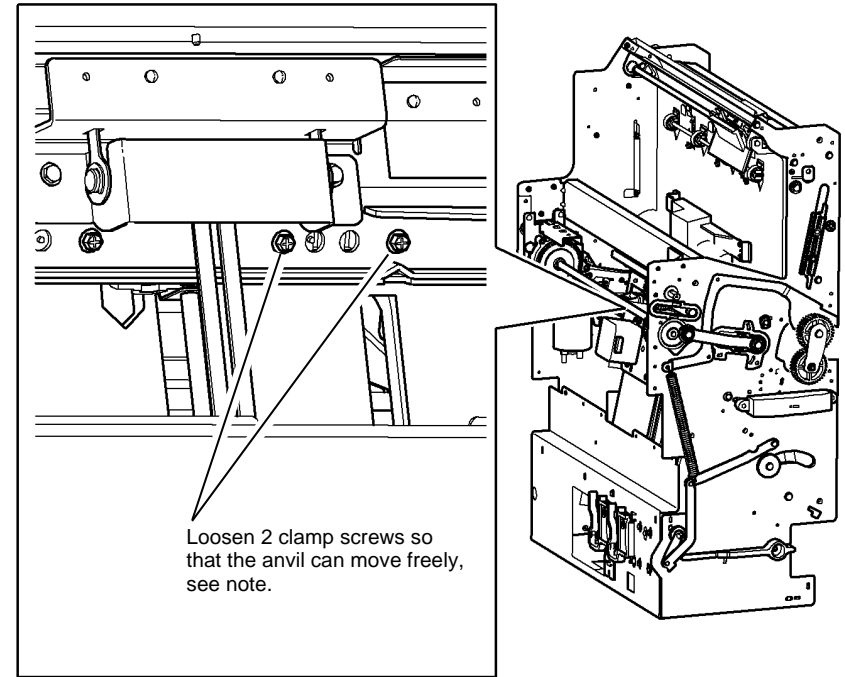
X-1-0783-A

4. **Figure 2**, loosen the anvil.

Figure 2 Loosening the anvil

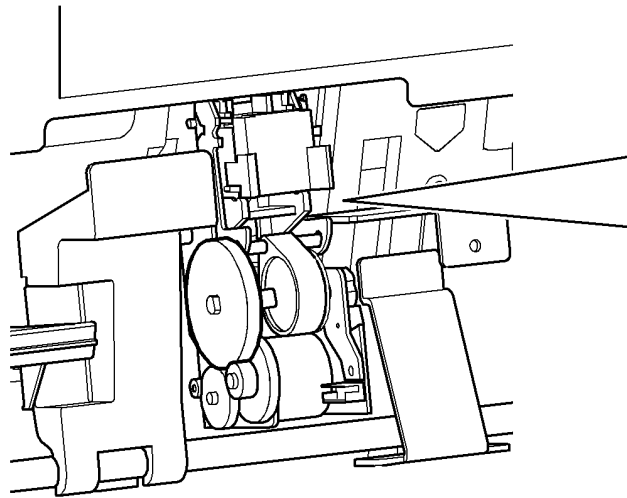
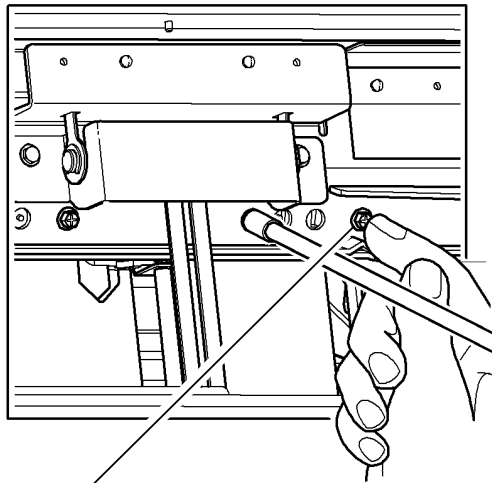
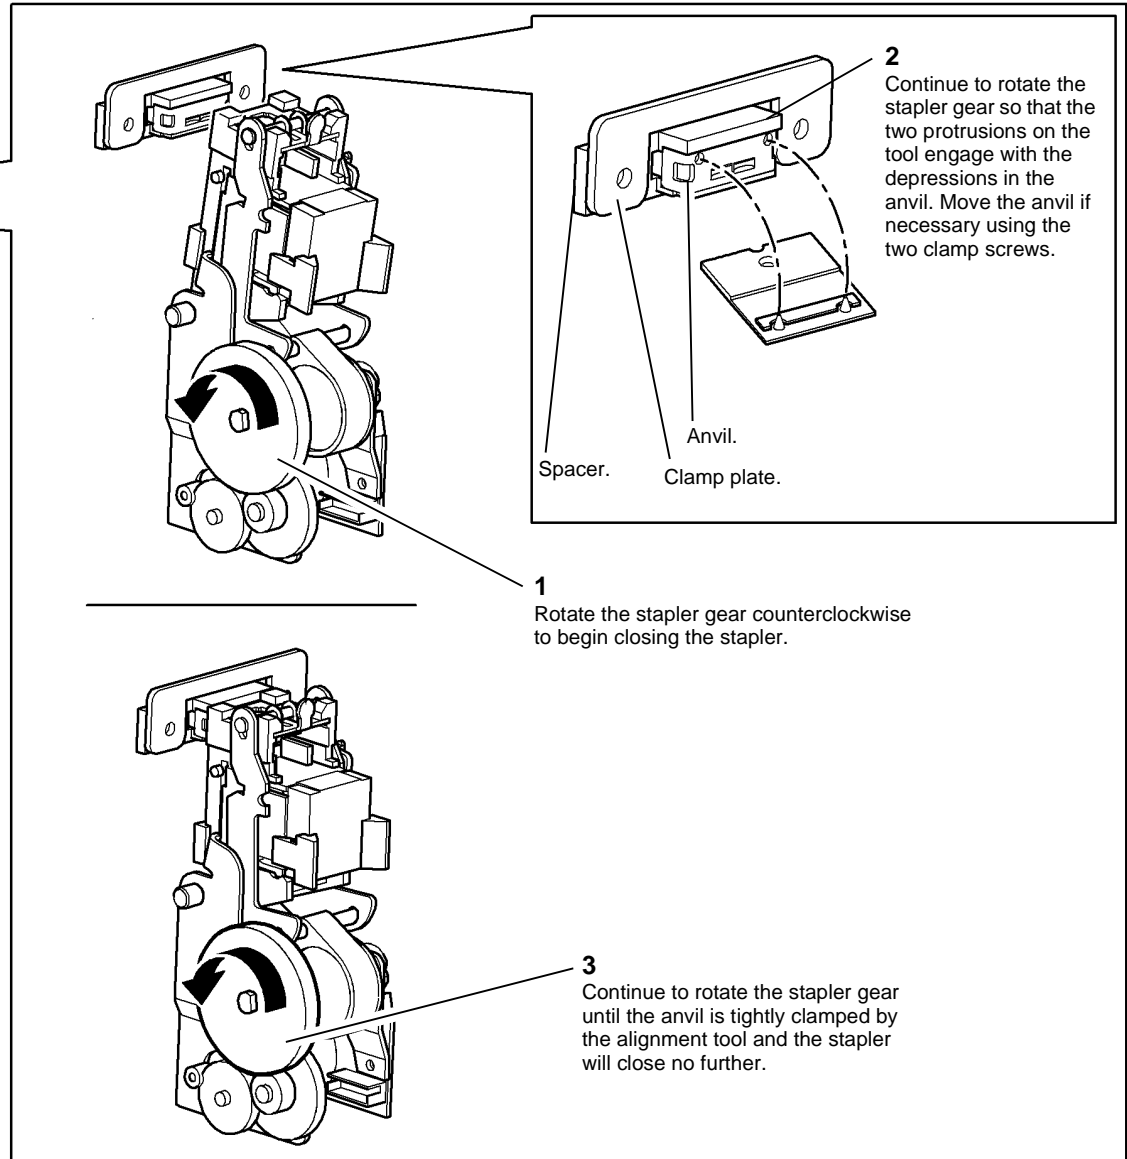
5. Figure 3, close the stapler.

4
Tighten the two screws alternately a little at a time, while holding the free screw with a finger. Ensure that the anvil does not move as the screws are tightened.

1
Rotate the stapler gear counterclockwise to begin closing the stapler.

3
Continue to rotate the stapler gear until the anvil is tightly clamped by the alignment tool and the stapler will close no further.

NOTE: Take great care not to drop the anvil, spacer or clamp plate, **Figure 3**, as they can fall to the bottom of the BM module. If parts need to be retrieved from the bottom of the BM module it may be necessary to tilt the whole HVF BM to make the loose parts slide to the centre of the base, from where they can be easily removed.
