708P91368
September 2017

Xerox® AltaLink® B8090 Family Multifunction Printer Service Manual

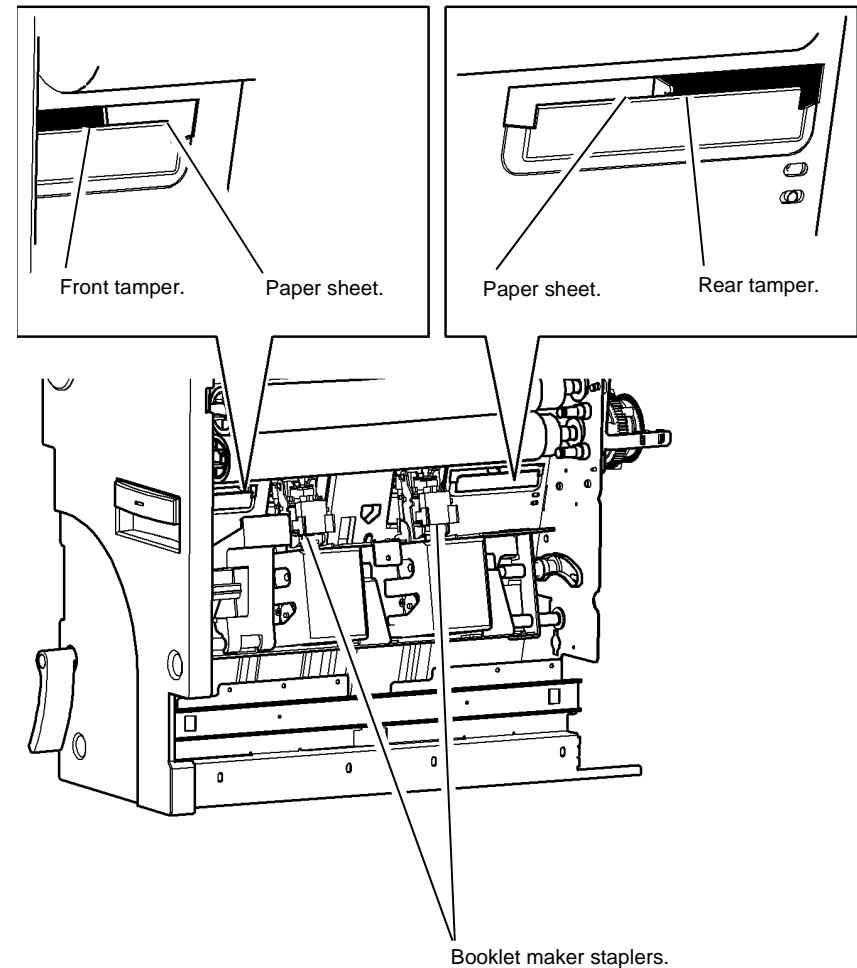
X-1-0785-A

Figure 1 Observing the tamper positions.

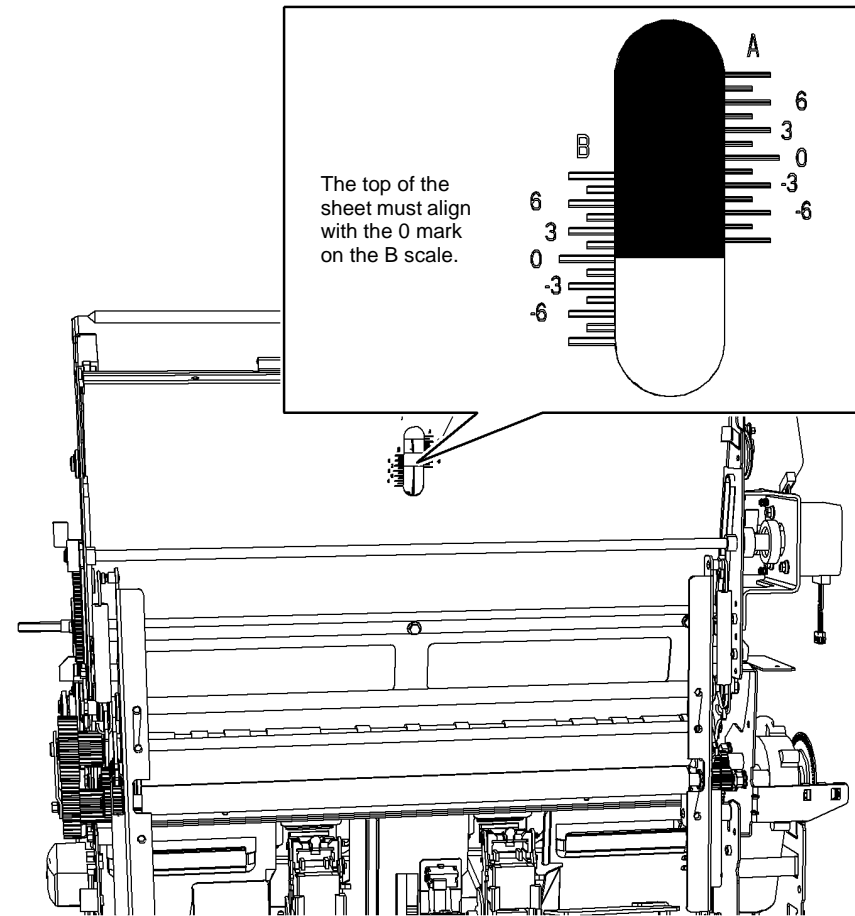
X-1-0786-A

Figure 1 Top edge alignment

1. Open the HVF BM front door and insert an interlock cheater into the front door interlock switch.
2. Fully pull out the BM module and release the jam clearance handle [PL 12.150 Item 8](#), fully open the paper guide [PL 12.150 Item 7](#).
3. Enter Diagnostic Routine [dC330](#) code 012-255 BM Backstop Motor, select Start, allow the backstop to raise to the receive position (where it will pause), select Stop.
4. Insert a single sheet of A4 paper short edge downward into the booklet maker compiling area, so that it rests on the backstop and is approximately central front to back. Tuck the top of the sheet behind the BM entry roll, [PL 12.150 Item 15](#).
5. If the BM right hand cover does not have a viewing hole, remove the BM right hand cover, [REP 12.56-171](#).
6. [Figure 1](#), check the alignment of the sheet against the scale.

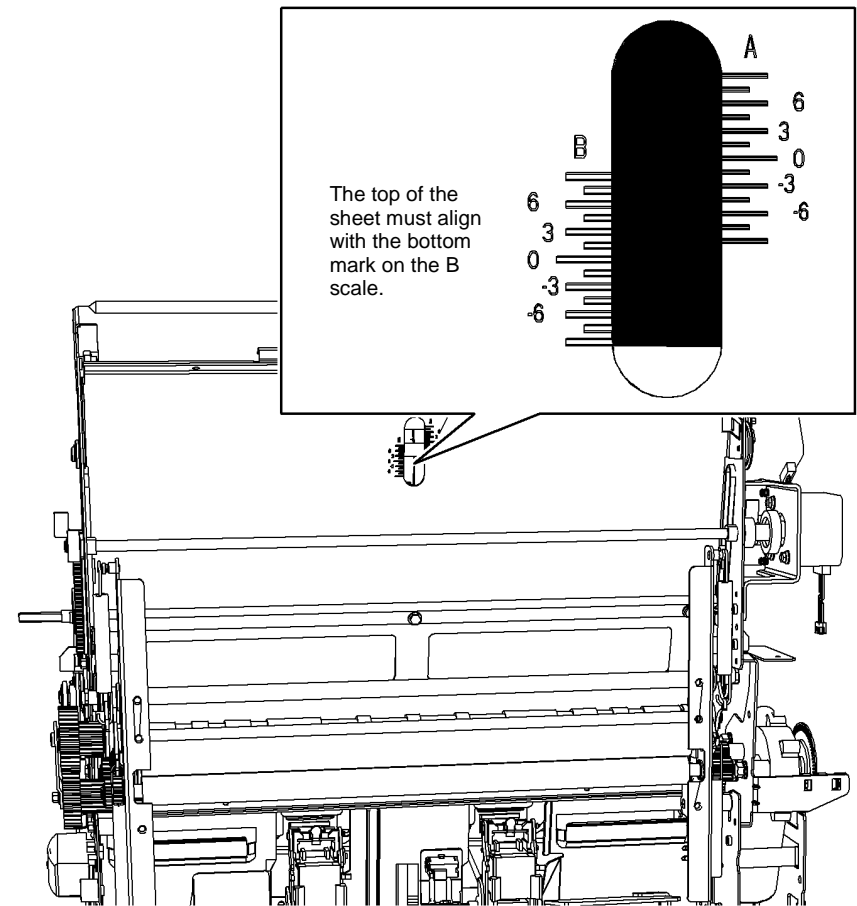
X-1-0787-A

- Insert a single sheet of 8.5 X 11 inch paper short edge downward into the booklet maker compiling area, so that it rests on the backstop and is approximately central front to back. Tuck the top of the sheet behind the BM entry roll, [PL 12.150 Item 15](#).

- If the BM right hand cover does not have a viewing hole, remove the BM right hand cover, [REP 12.56-171](#).
- [Figure 2](#), check the alignment of the sheet against the scale.

Figure 2 Top edge alignment

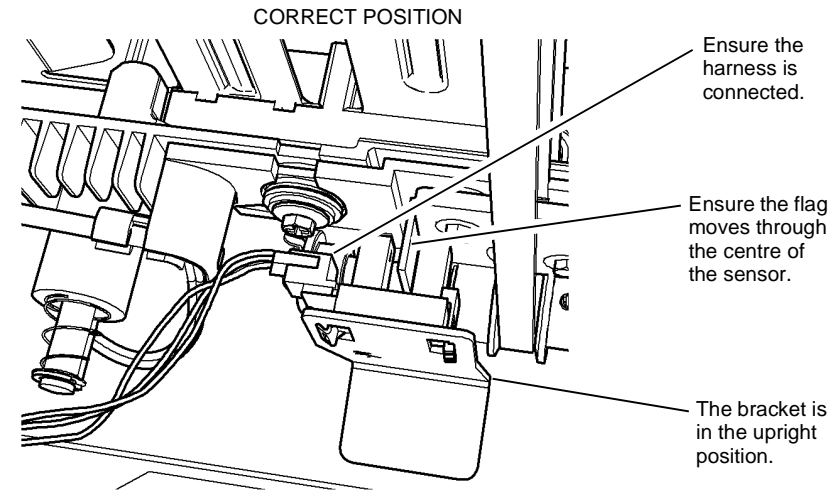
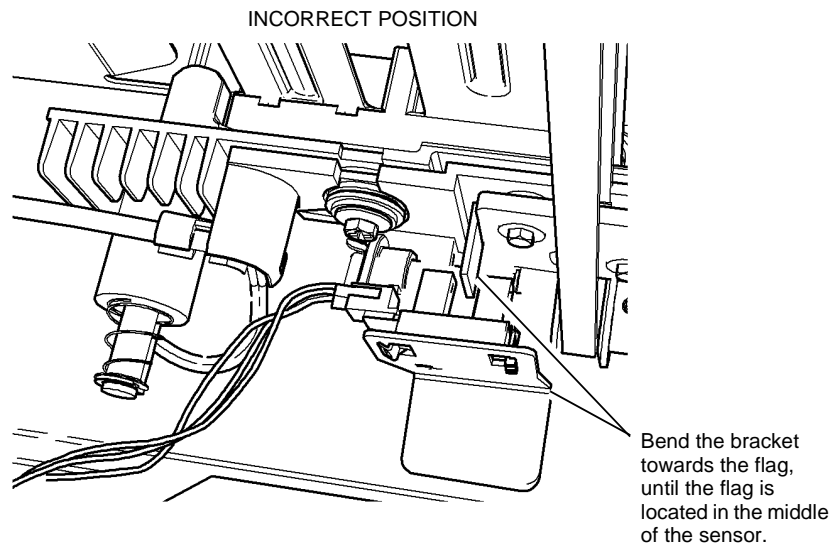
X-1-0788-A

Figure 1 Booklet maker back stop sensor bracket

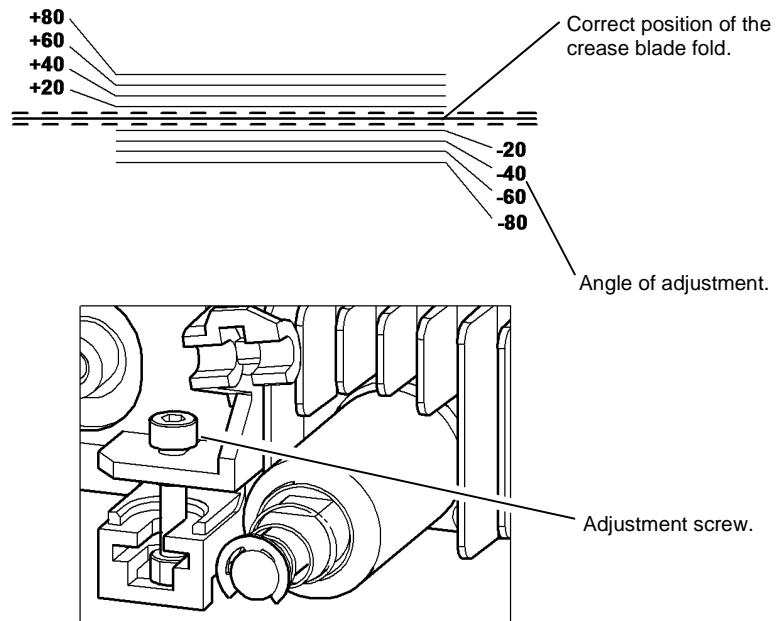
X-1-0789-A

Figure 1 Booklet crease adjustment

1. Slide out the booklet maker and locate the adjustment screw on the booklet backstop, Figure 1.
2. Use a 2.5 mm allen head driver and turn the adjustment screw as follows:
 - Turn the screw clockwise to rotate the crease clockwise relative to the centre line.
 - Turn the screw anti-clockwise to rotate the crease anti-clockwise relative to the centre line.
 - One half turn of the adjustment screw will change the crease angle approximately 3 to 4 mm over the length of the crease.
3. Run a copy job of 3 stapled 4 sheet booklets to check that the crease is in the centre of the book. Repeat the adjustment if necessary.

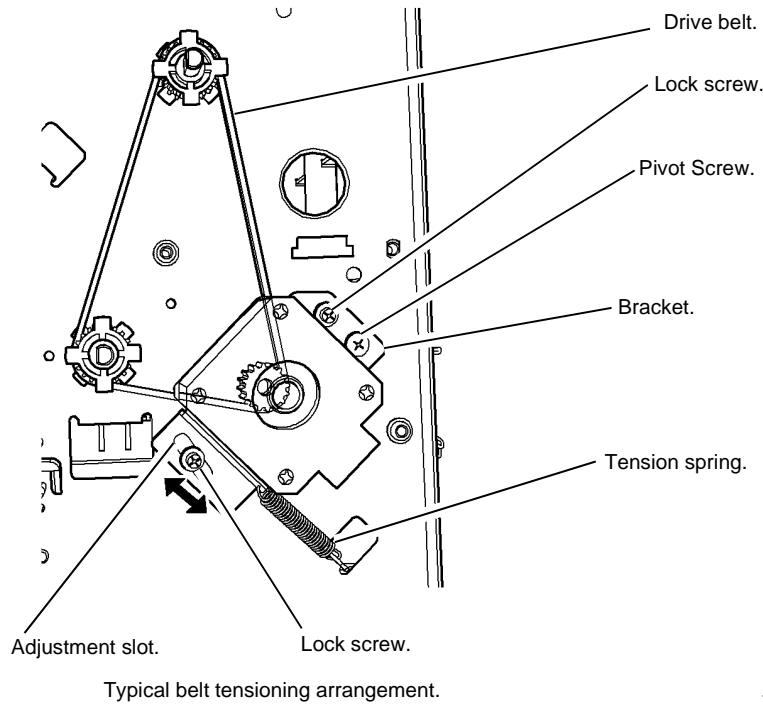
1. [Figure 1](#) shows a typical arrangement. Press the belt midway between pulleys and check that the bracket moves in the direction of the spring pull; slacken the bracket screws if necessary.
2. Release the belt and allow the spring to pull the bracket and tension the drive belt then tighten the lock and bracket screws.

NOTE: Check the belt condition and routing if the tension spring is not extended or the locking screw is at the end of the bracket adjustment slot.

Figure 1 Drive Belt Tensioning

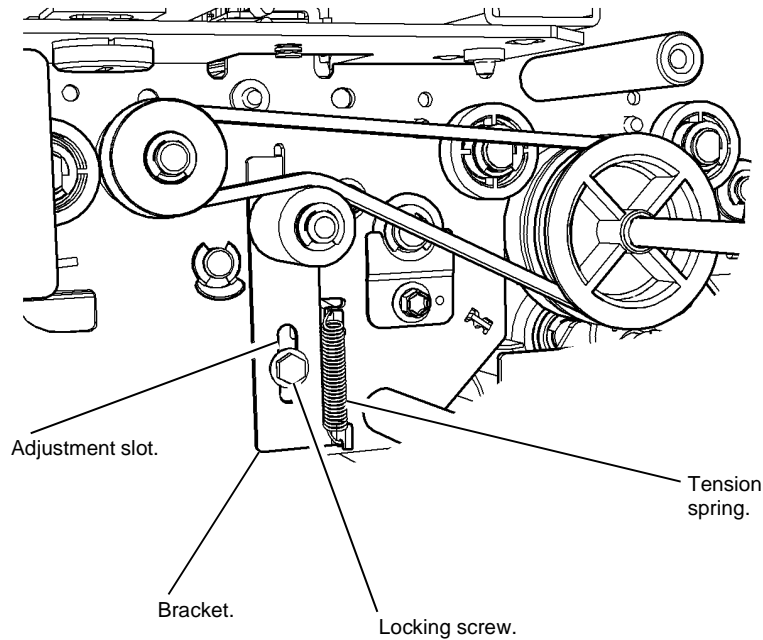
X-1-0791-A

Typical belt tensioning arrangement.

Figure 1 Drive Belt Tensioning

1. [Figure 1](#) shows a typical arrangement. Loosen the adjustment screw and allow the spring to tension the belt.
2. Tighten the adjustment screw.
3. If no more adjustment is available, but the belt is still slack, install new components as necessary.

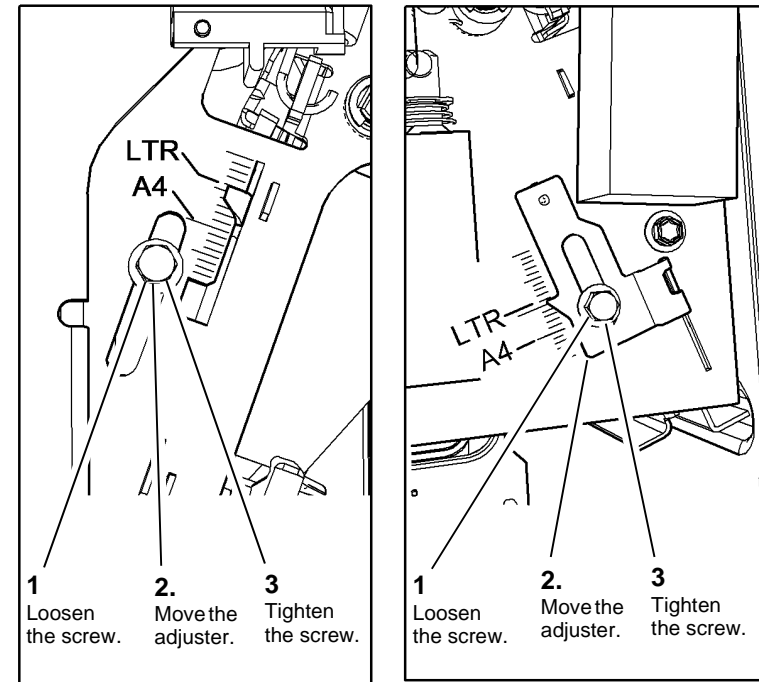
X-1-0794-A

Figure 3 Set the paper size adjusters.

Figure 2. The folds marked B are created within the tri-folder module. The length of the B fold is determined by the position of the paper setting adjusters. If necessary remove the front door, PL 12.200 Item 2, front cover PL 12.200 Item 12 and the rear cover PL 12.200 Item 3, then reposition the paper setting adjusters. Figure 3. An adjustment of 1 graduation on the paper size adjuster scale will adjust the position of fold B by 1 mm.

- Raise the paper setting adjusters to decrease fold B.
- Lower the paper setting adjusters to increase fold B.

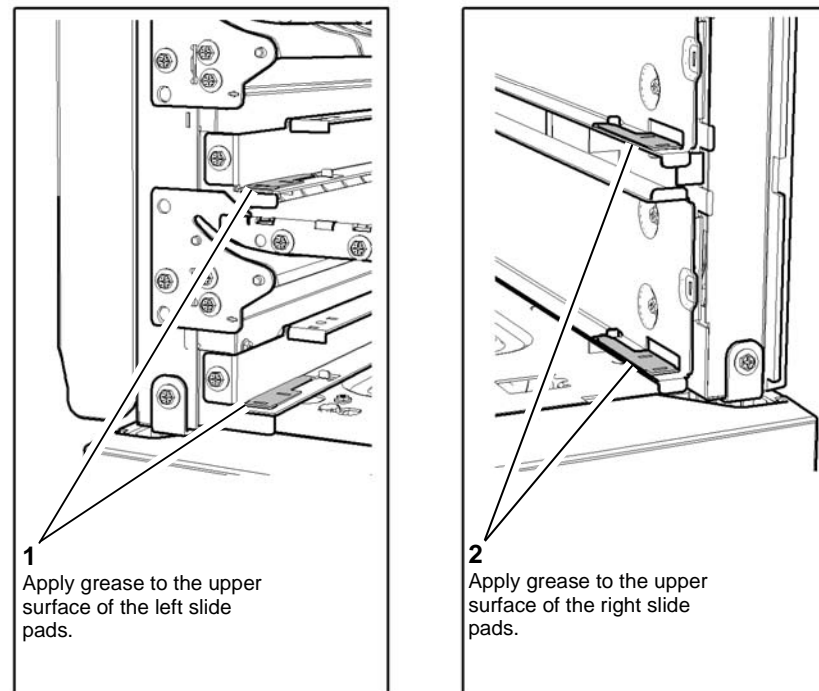
X-1-1207-A

Figure 1 Tray 1 and 2 slide pads

1. Remove tray 1 and 2, [REP 70.1](#).
2. If the trays do not slide easily, apply plastislip grease, [PL 26.10 Item 8](#), to lubricate the slide pads, [Figure 1](#).

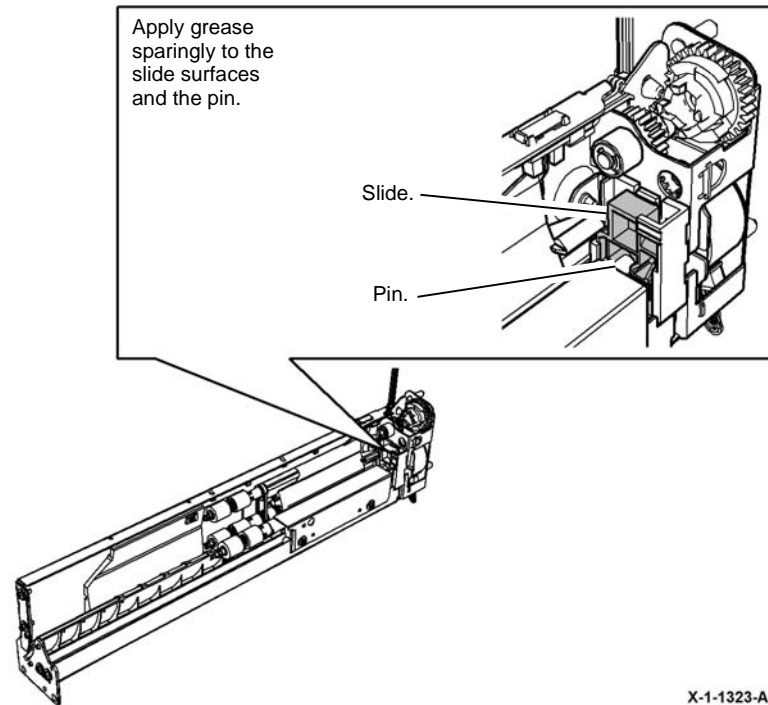
1. Remove tray 1 and 2, [REP 70.1](#).
2. Remove the tray 1 and tray 2 paper feed assemblies, [REP 80.1](#).
3. Check that the actuator mechanism operates smoothly, if necessary apply plastislip grease, [PL 26.10 Item 8](#), to lubricate the actuator, [Figure 2](#).

Figure 2 Actuator lubrication

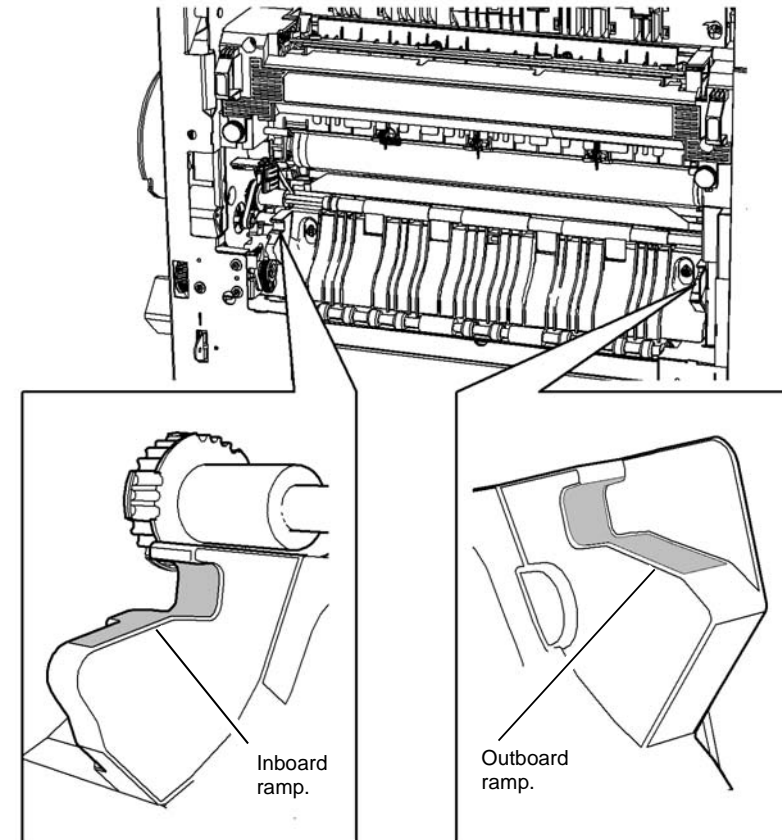
- 1**
Clean any residual lubricant or contamination from the two areas.

- 2**
Apply plastislip grease very sparingly to the two areas.

1. Open the left door.
2. Lubricate the registration transport location ramps with plastislip grease, [PL 26.10 Item 8](#), [Figure 3](#).

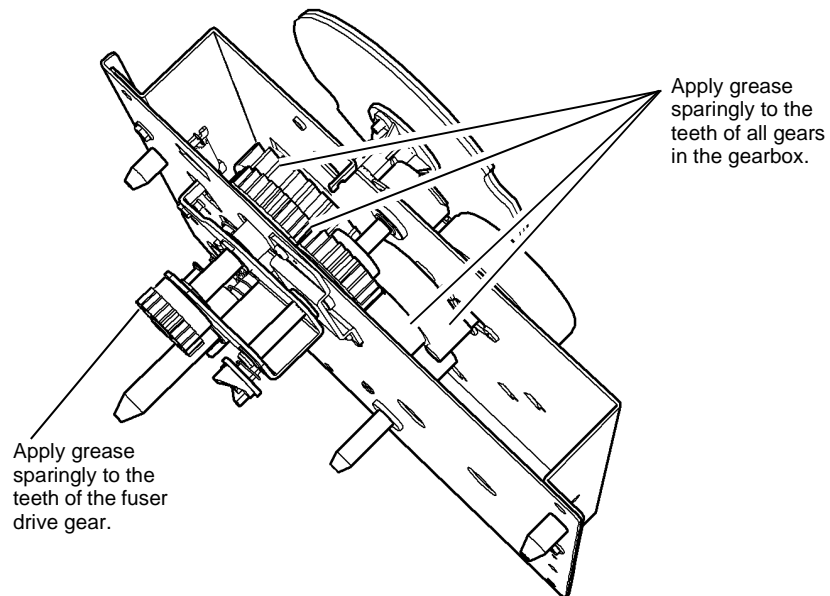
1. Remove the main drive module, [REP 40.1](#).
2. Check that the gears are adequately lubricated, if necessary apply plastislip grease, [PL 26.10 Item 8](#), to lubricate the main drive module, [Figure 4](#).

Figure 4 Main drive module

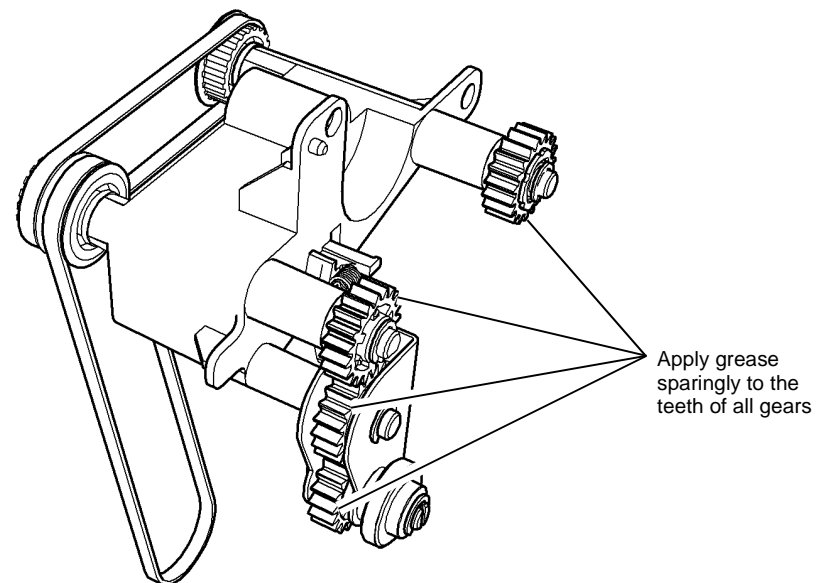
X-1-1326-A

Figure 5 Exit drive assembly

1. Remove the exit drive assembly, [REP 10.2](#).
2. Check that the gears are adequately lubricated, if necessary apply plastislip grease, [PL 26.10 Item 8](#), to lubricate the exit drive assembly gears, [Figure 5](#).

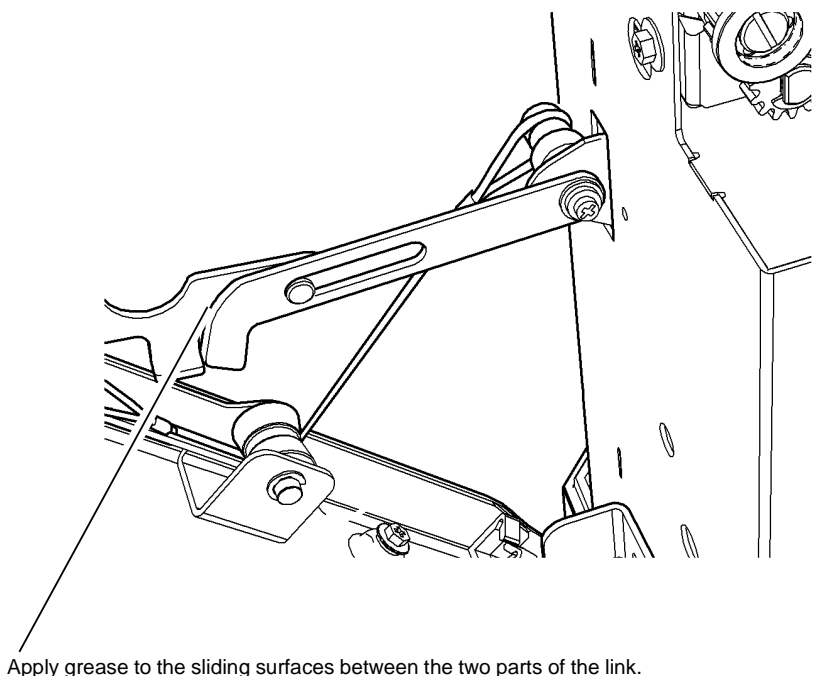
X-1-1411-A

1. Open the left door.
2. **Figure 6**, check that the link assembly is adequately lubricated, if necessary apply plastislip grease, **PL 26.10 Item 8**.

Figure 6 Door link lubrication

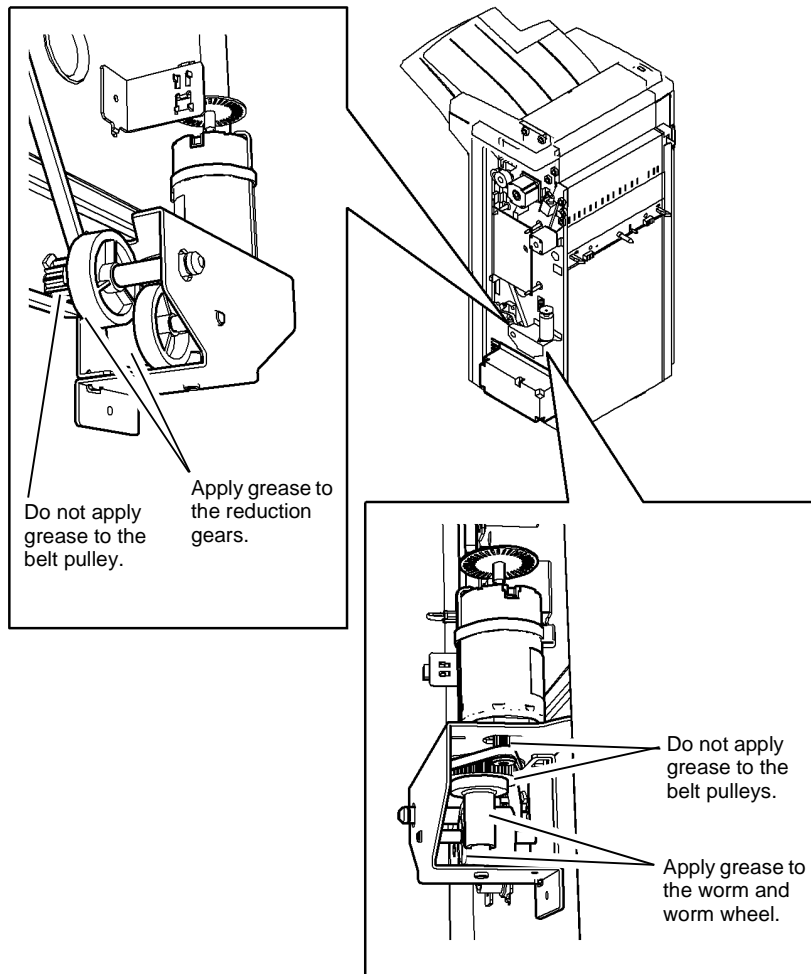
X-1-1319-A

Figure 7 Worm and gears

1. Remove the 2K LCSS top cover and rear cover, [REP 12.1-110](#).
2. Check that the worm, worm wheel and reduction gears are adequately lubricated, if necessary use plastislip grease, [PL 26.10 Item 8](#), to lubricate the components, [Figure 7](#).

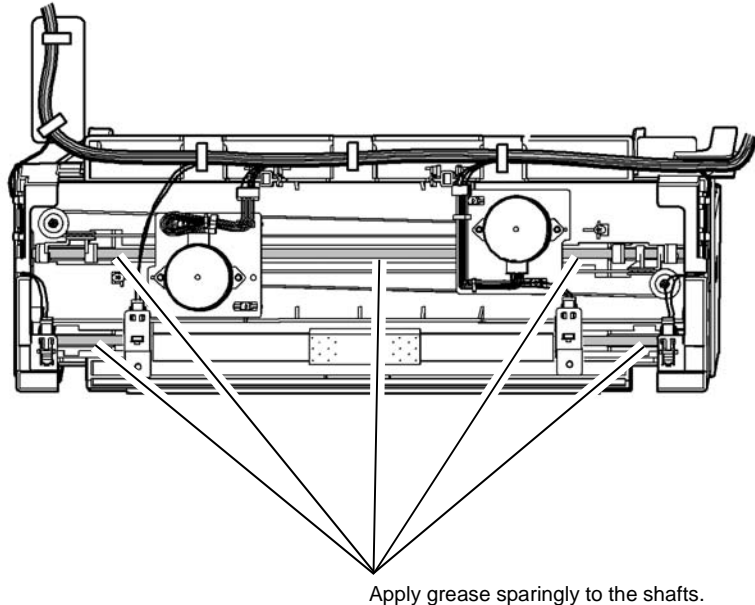
X-1-1321-A

Figure 8 Lower vertical slides

1. Remove the 2K LCSS top cover, [REP 12.1-110](#) or LVF BM top cover, [REP 12.1-150](#).
2. Check that the two tamper shafts are adequately lubricated, if necessary use plastislip grease, [PL 26.10 Item 8](#), to lubricate the tamper assembly, [Figure 8](#).

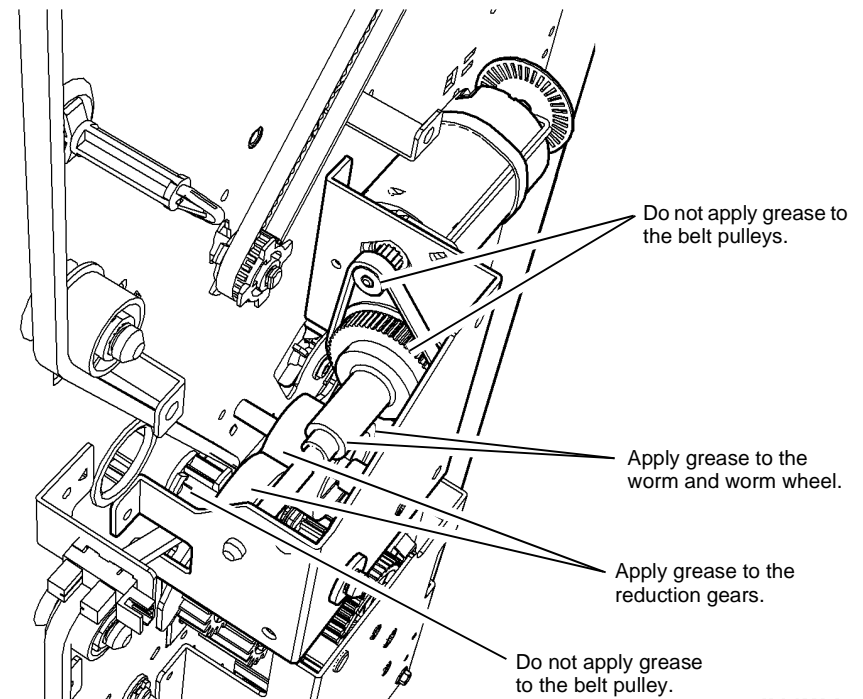
X-1-1320-A

Figure 9 Worm and gears

1. Remove the LVF BM top cover and rear cover, [REP 12.1-150](#).
2. Check that the worm, worm wheel and reduction gears are adequately lubricated, if necessary use plastislip grease, [PL 26.10 Item 8](#), to lubricate the components, [Figure 9](#).

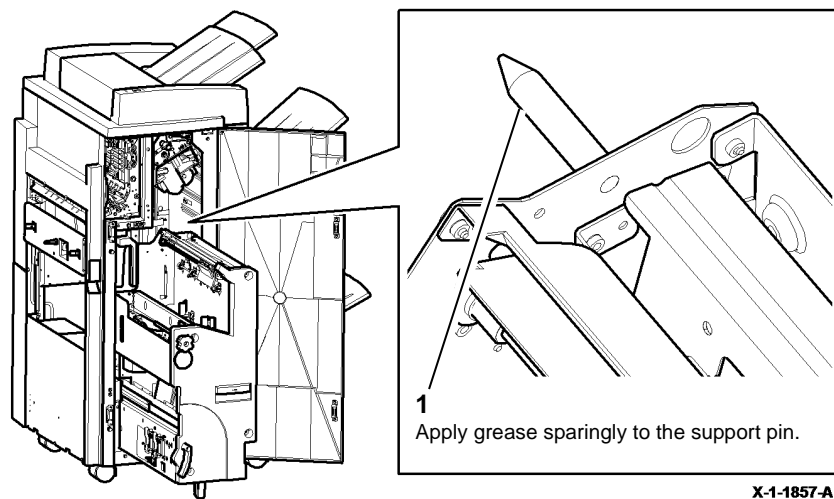
1. Open the BM front door.
2. Fully pull out the BM unit.
3. Figure 2, use plastislip grease, [PL 26.10 Item 4](#), to lubricate the BM support pin.

Figure 10 Support pin lubrication

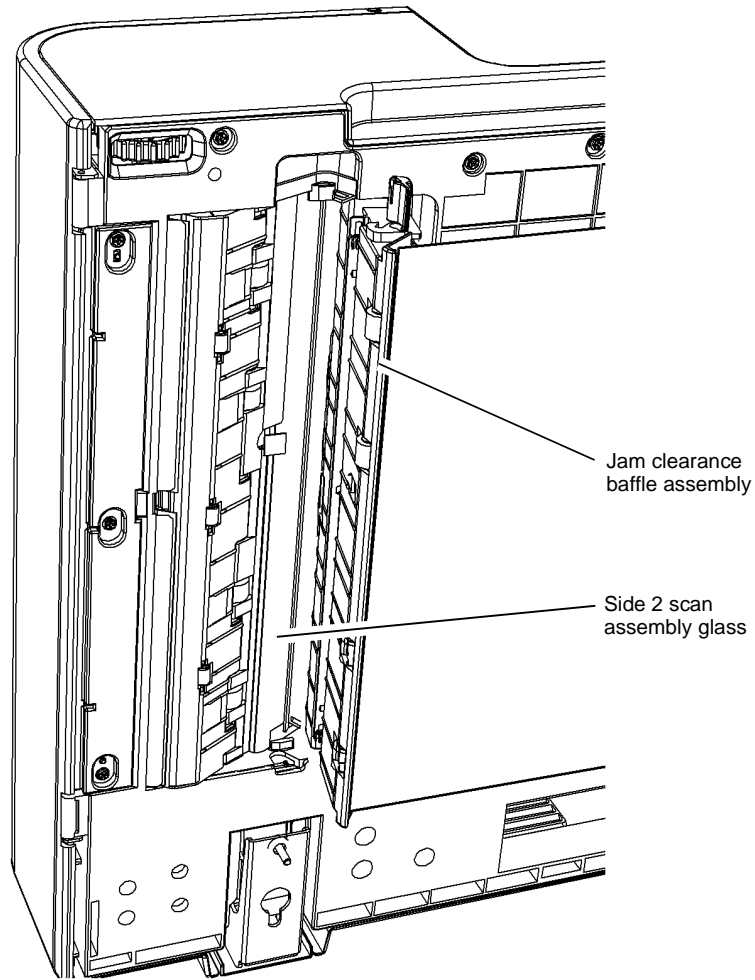
X-1-1858-A

Figure 1 Component location

2. Lower the jam clearance baffle assembly, [Figure 1](#).

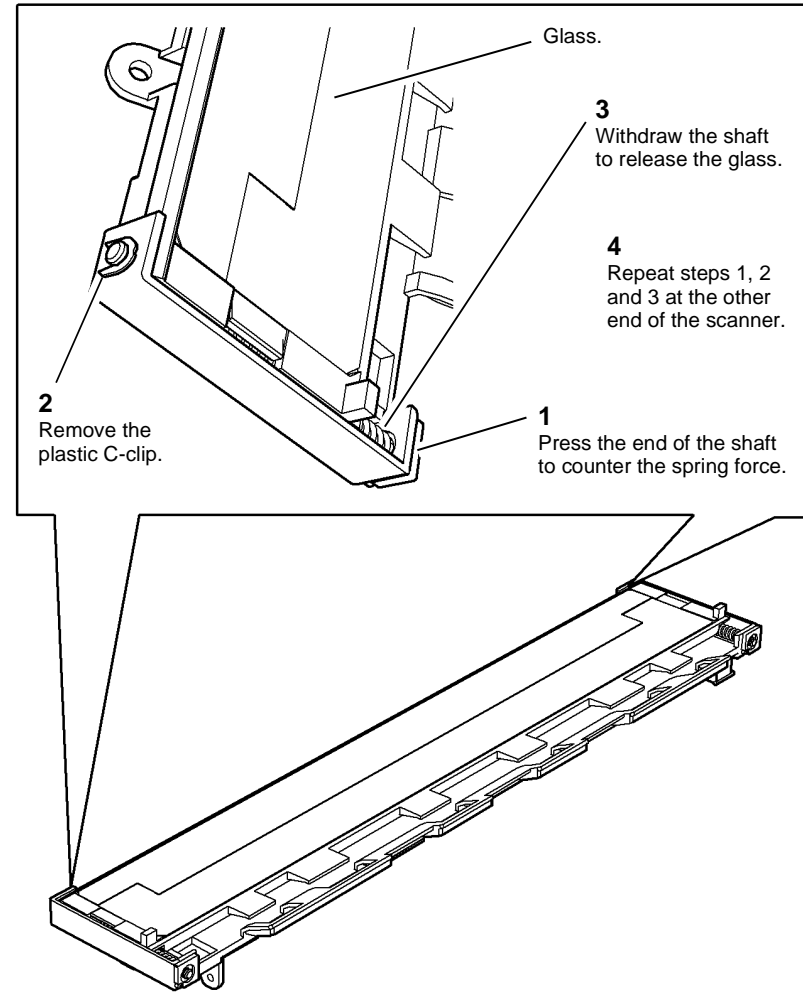
X-1-1859-A

Figure 2 Side 2 scan glass assembly removal

1. Remove the side 2 scan assembly, [REP 60.6](#).
2. Remove the side 2 scan assembly glass, [Figure 2](#).

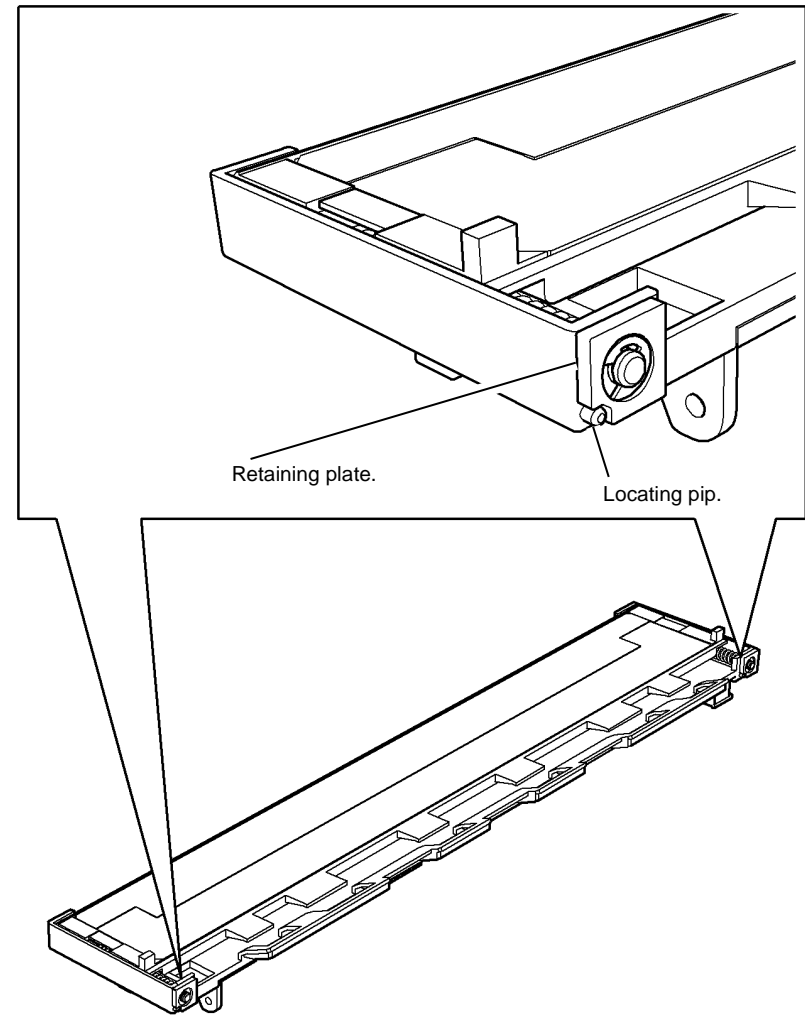
X-1-1869-A

Figure 3 Retaining plate location

3. Use a microfiber wiper, [PL 26.10 Item 13](#), dampened with antistatic fluid, [PL 26.10 Item 19](#) to clean the inside surface of the side 2 scan assembly glass.
4. Use a microfiber wiper, [PL 26.10 Item 13](#), to polish the inside surface of the side 2 scan assembly glass.
5. Reverse the removal process in [Figure 2](#) to replace the side 2 scan assembly glass.
6. Ensure that the retaining plate on the end of each shaft is positioned correctly relative to the locating pips on the side 2 scan assembly, [Figure 3](#).

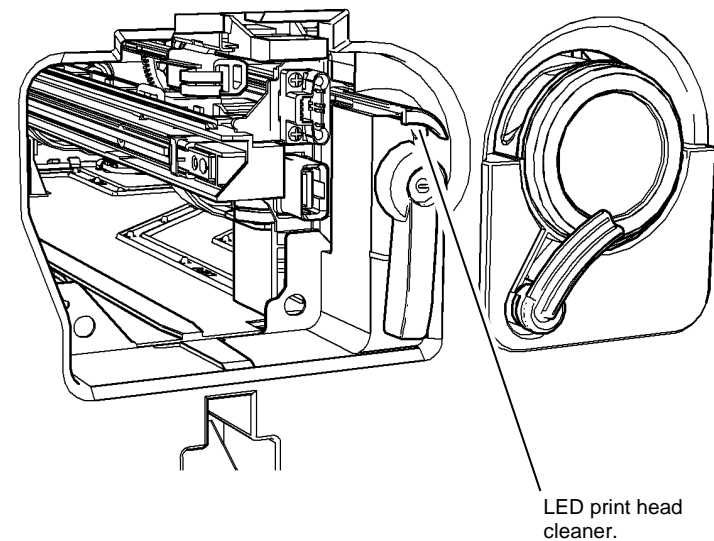
1. Open the front door assembly, [PL 28.10 Item 5](#).
2. Cam the LED print head away from the print cartridge.
3. Manually move the LED print head cleaner fully out, then in 3 times, [Figure 1](#).

Figure 1 Component location

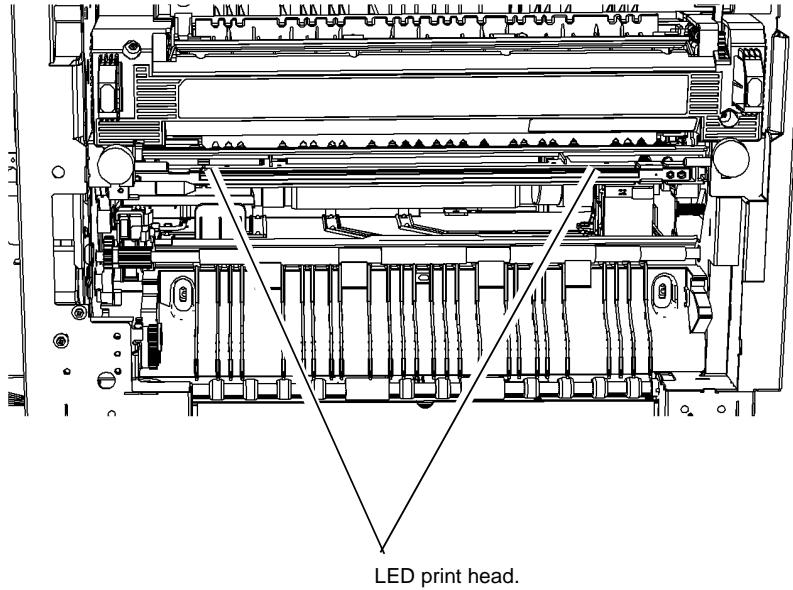
X-1-1861-A

Figure 2 Component location

- c. Use a lint free wiper, PL 26.10 Item 13 dampened with cleaning fluid, PL 26.10 Item 22 to clean the LED print head, Figure 2.

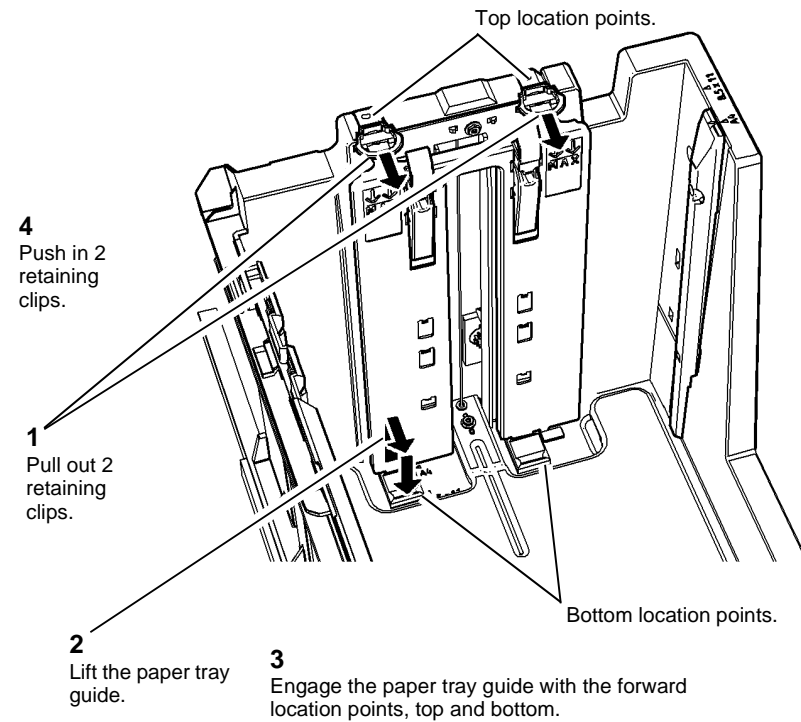
X-1-0795-A

Figure 1 Rear guide re-position

1. Remove tray 2, [REP 70.1](#).
2. Pull out the tray to be adjusted. Remove the paper from the tray.
3. To reset the paper tray guides:
 - Refer to [Figure 1](#) and [Figure 2](#) to change the paper tray guides from A4 paper size to 8.5x11 inch paper size.
 - Refer to [Figure 3](#) to change the paper guides from A4 paper size to 8.5x11 inch paper size.
 - Refer to [Figure 4](#) and [Figure 5](#) to change the paper tray guides and paper guides from 8.5x11 inch paper size to A4 paper size.
 - Refer to [Figure 6](#) to change the paper guides from 8.5x11 inch paper size to A4 paper size.

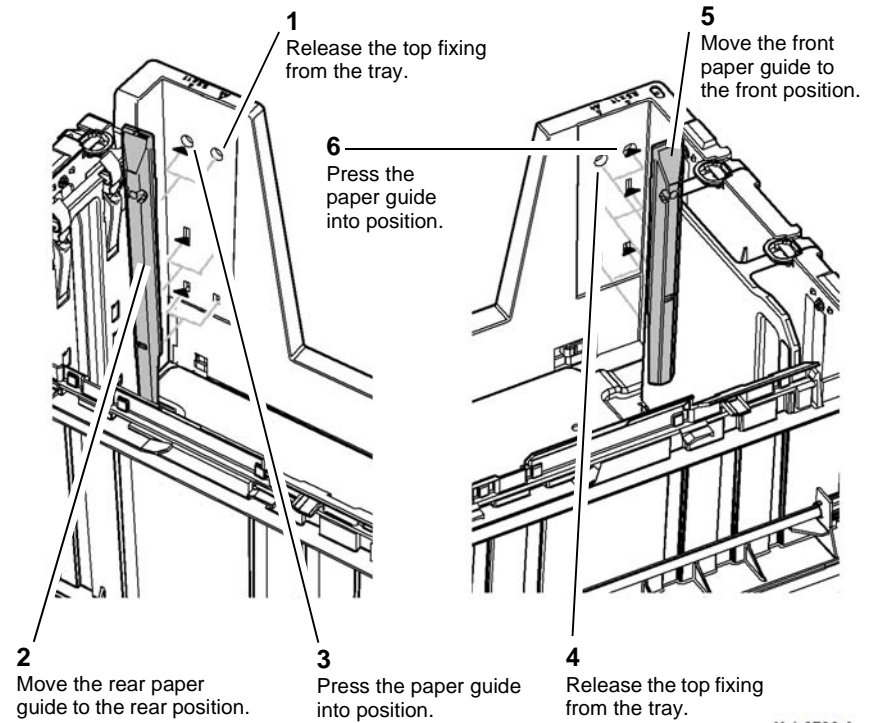
X-1-0796-A

Figure 3 Paper guides re-position

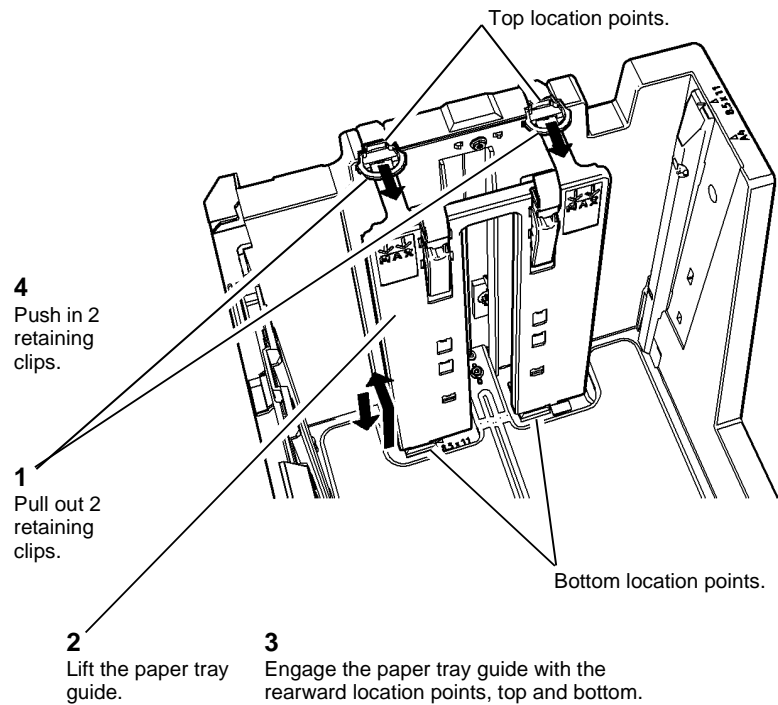
X-1-0797-A

Figure 4 Rear guide re-position

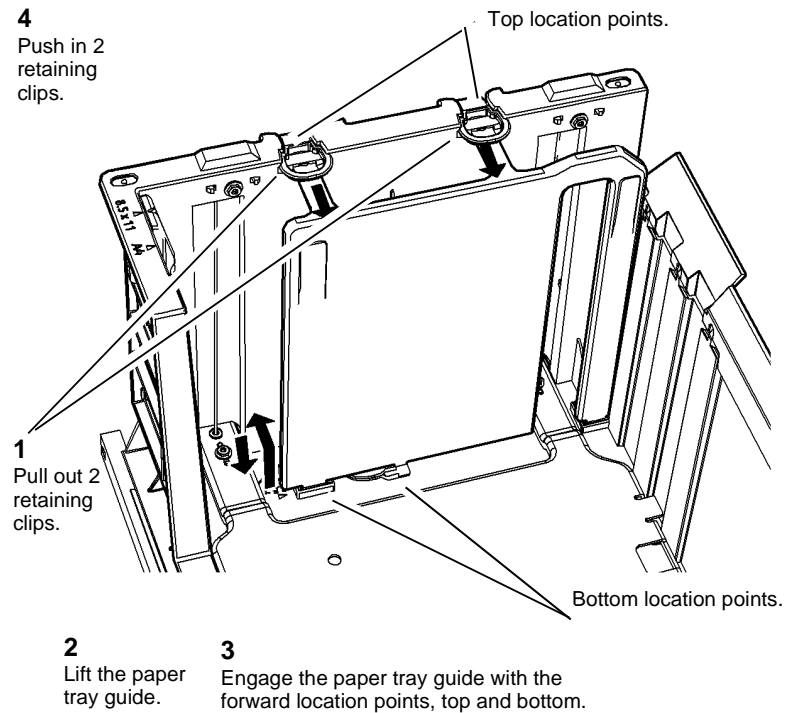
X-1-1012-A

Figure 5 Front guide re-position

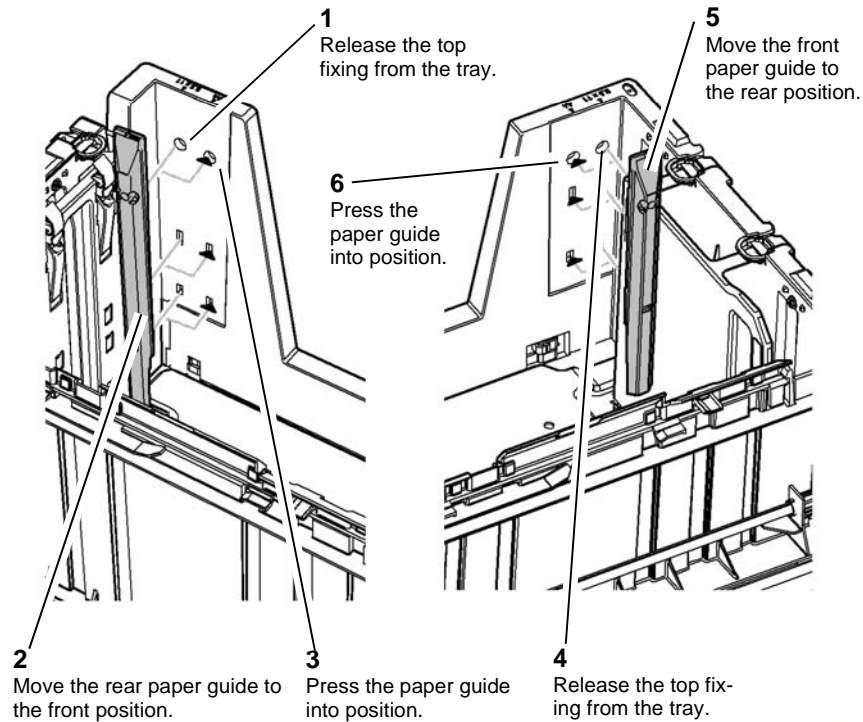
X-1-0798-A

Figure 6 Paper guides re-position

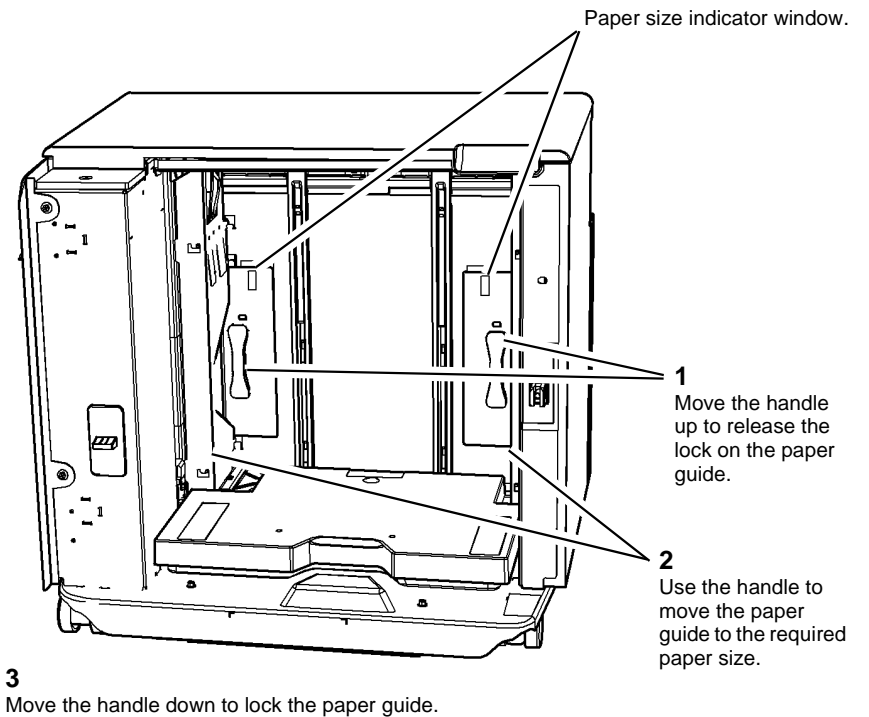
X-1-1885-A

1. Open the tray 6 door and allow the tray to lower and remove the paper stack.
2. Adjust the paper guide to the required paper size, [Figure 1](#).

Figure 1 Paper guide adjustment

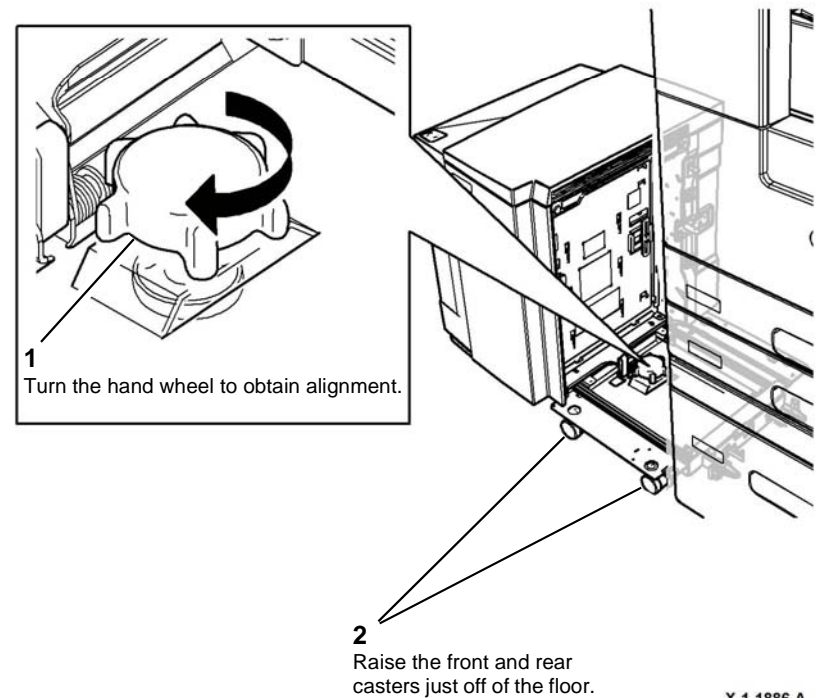
1. [Figure 1](#), turn the hand wheel in the centre of the tray 6 module to raise the casters off of the floor.

Figure 1 Tray 6 alignment

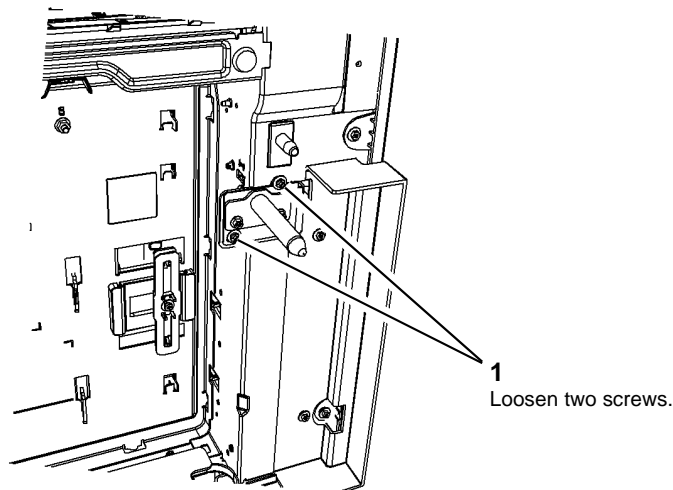
1. Loosen the two screws on the docking pin bracket, Figure 1.

Figure 1 Docking pin bracket

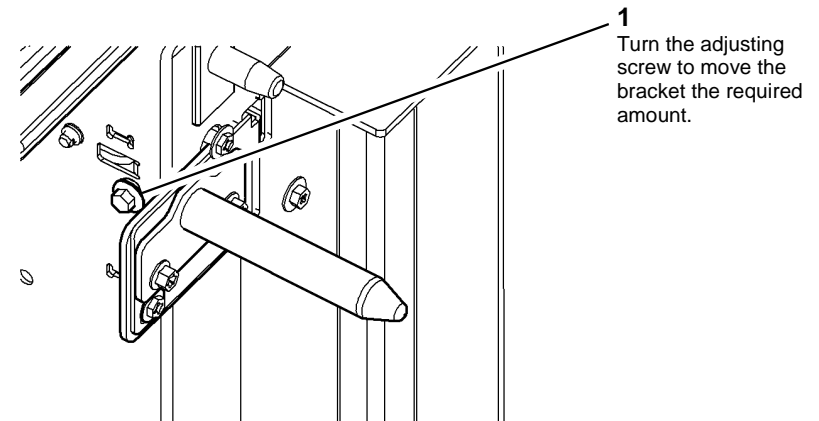
2. Turn the adjusting screw to move the docking pin bracket to the front or to the rear, Figure 2.

Figure 2 Adjusting screw

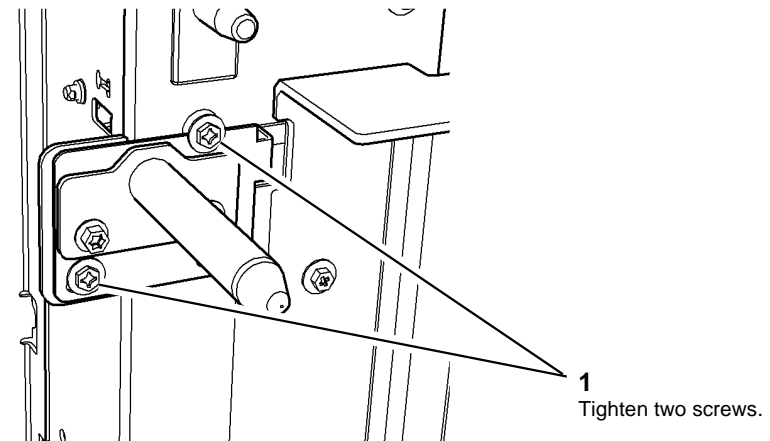
3. Secure the docking pin bracket, Figure 3.

Figure 3 Secure the docking pin bracket

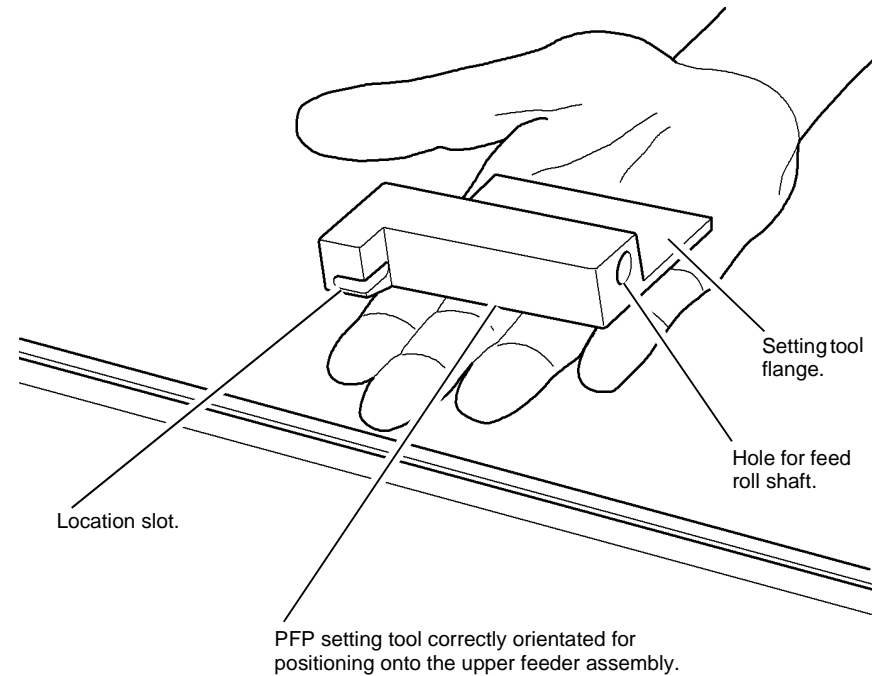
3. Prepare to locate the PFP setting tool onto the upper feed assembly, [Figure 1](#).

Figure 1 Tool orientation

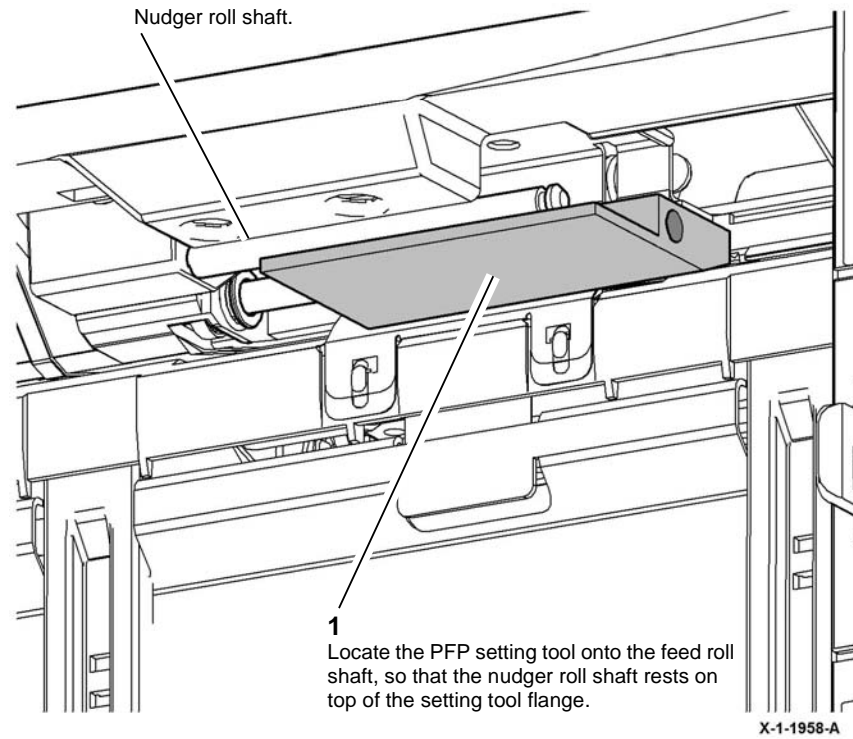
4. Install the PFP setting tool, [Figure 2](#).

Figure 2 Setting tool location
