708P91368
September 2017

Xerox® AltaLink® B8090 Family Multifunction Printer Service Manual

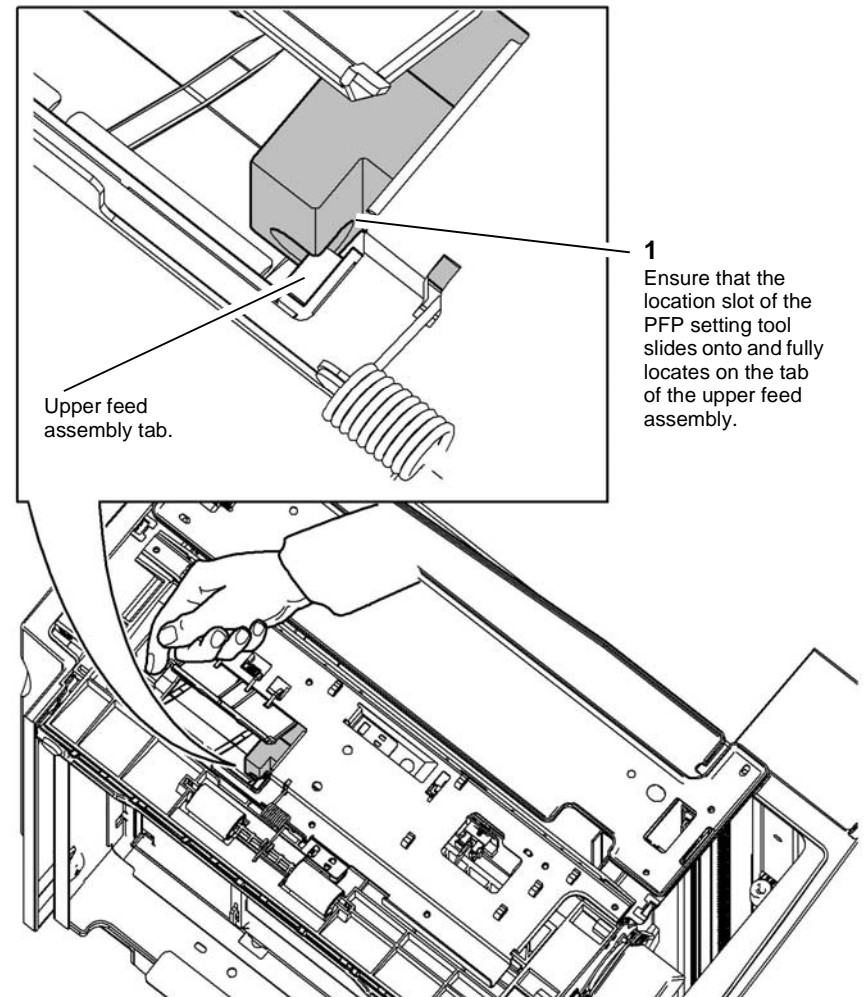
5. Engage the tab in the setting tool location slot, [Figure 3](#).

Figure 3 Tab location

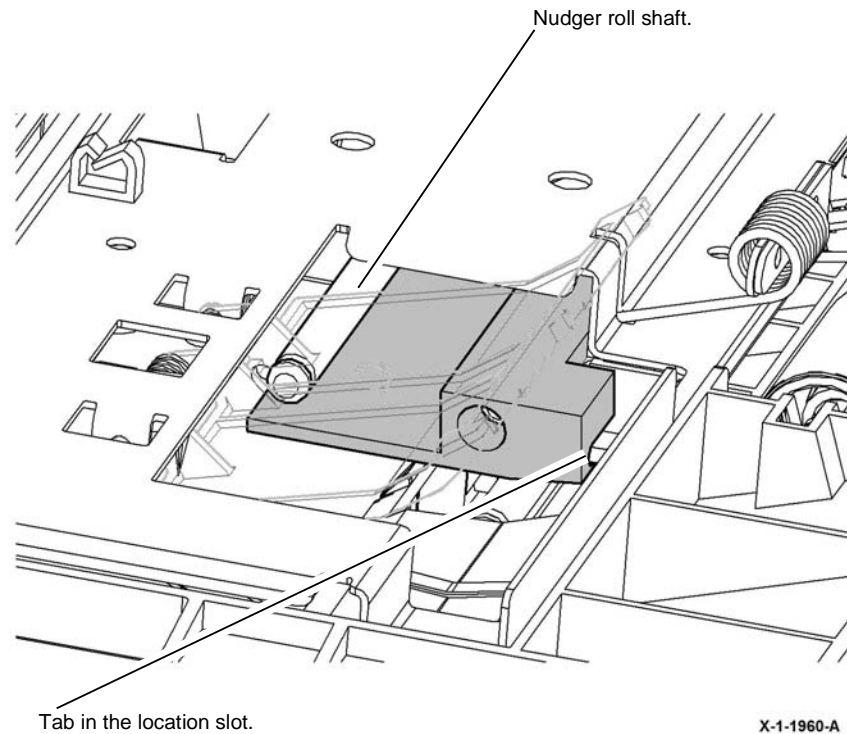
6. Check that the tool is correctly located, as shown in [Figure 4](#).

NOTE: In [Figure 4](#), the spring loaded access cover is shown in ghosted form for clarity.

Figure 4 Correct tool location

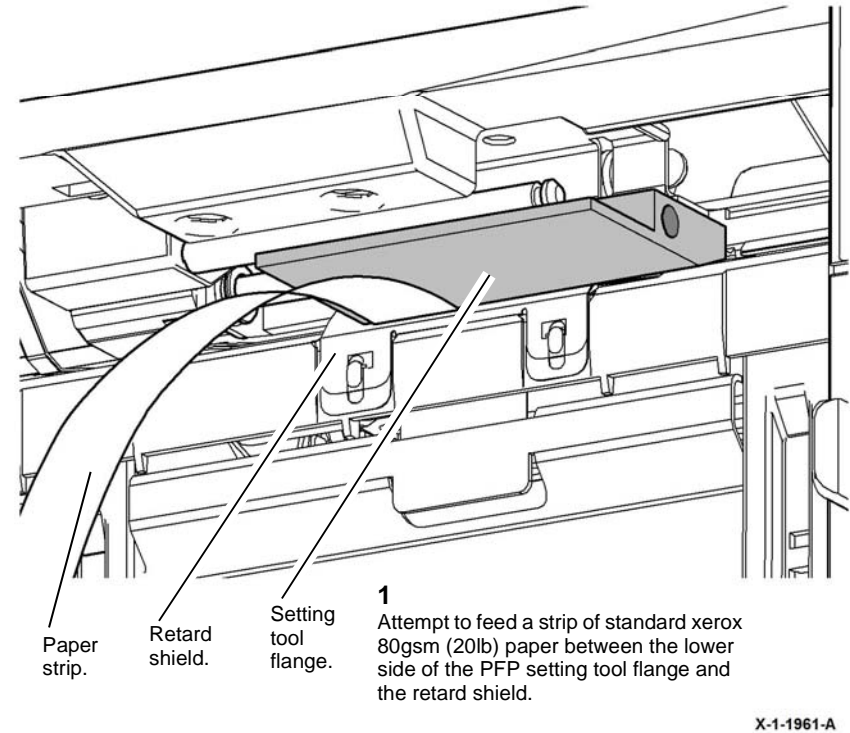
1. Check the position of the retard shield, [Figure 5](#).

Figure 5 Retard shield check

2. If the paper strip does not feed between the flange of the PFP setting tool and the retard shield then retard shield is positioned correctly, proceed to [Stack Height Sensor Check and Adjustment](#).
If the paper strip does feed between the flange of the PFP setting tool and the retard shield then the retard shield requires adjustment, continue at step 3.
3. Prepare to adjust the position of the retard shield, [Figure 6](#).

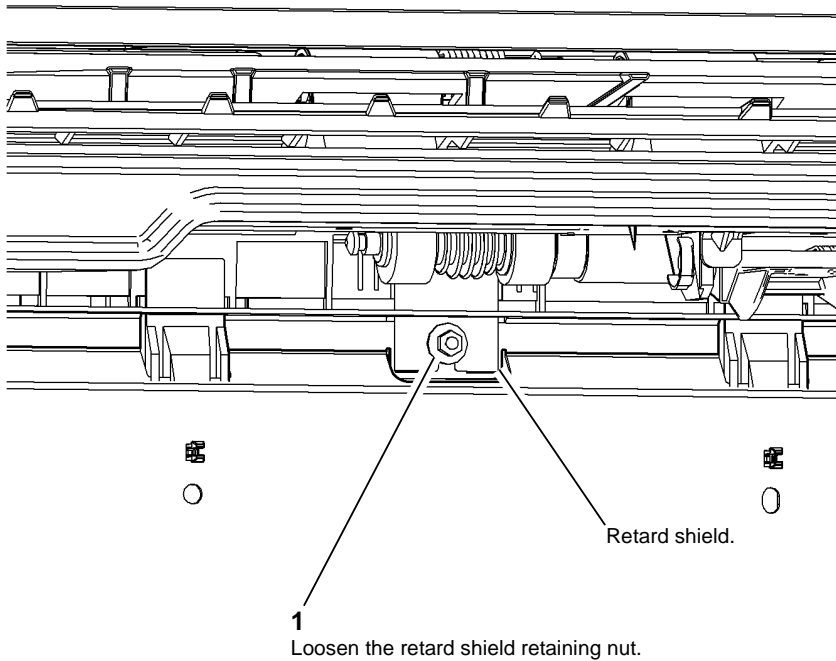
Figure 6 Preparation

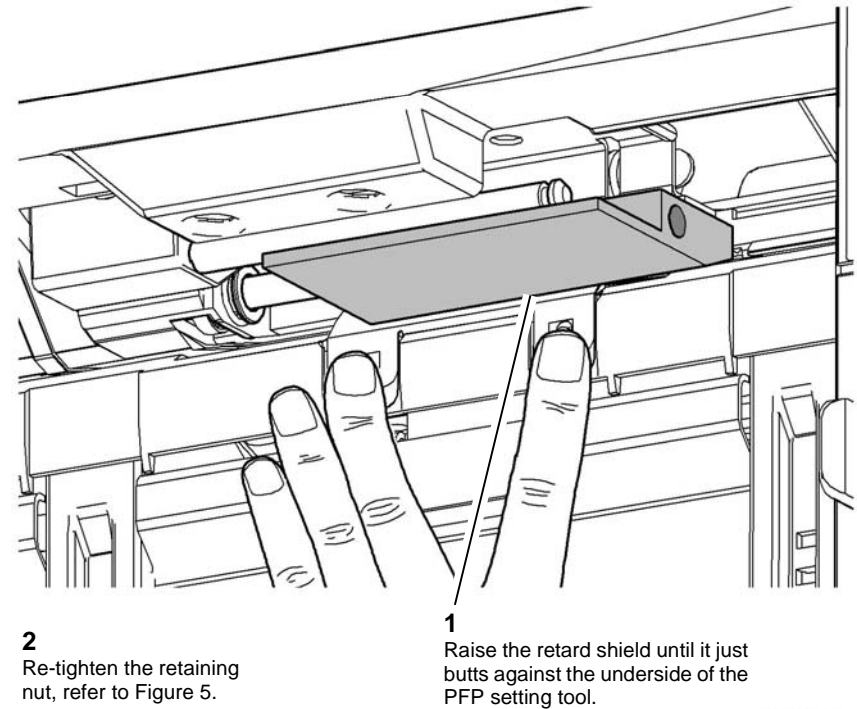
NOTE: Take care not to move the PFP setting tool as the retard shield is repositioned.

NOTE: Ensure the retard shield remains parallel to the upper feed assembly.

Figure 7 Retard shield adjustment

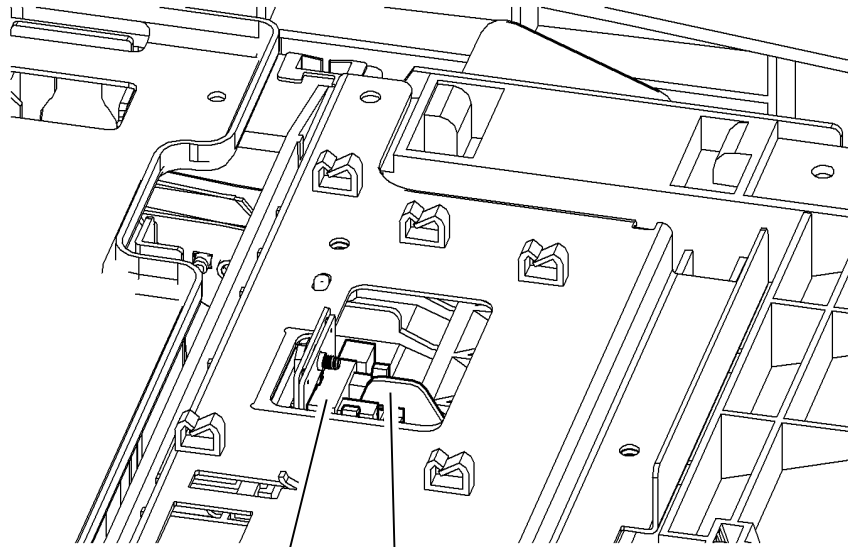
3. Check the position of the stack height sensor, [Figure 8](#).

NOTE: The sensor flag is part of the upper feed assembly top cover.

Stack height sensor.

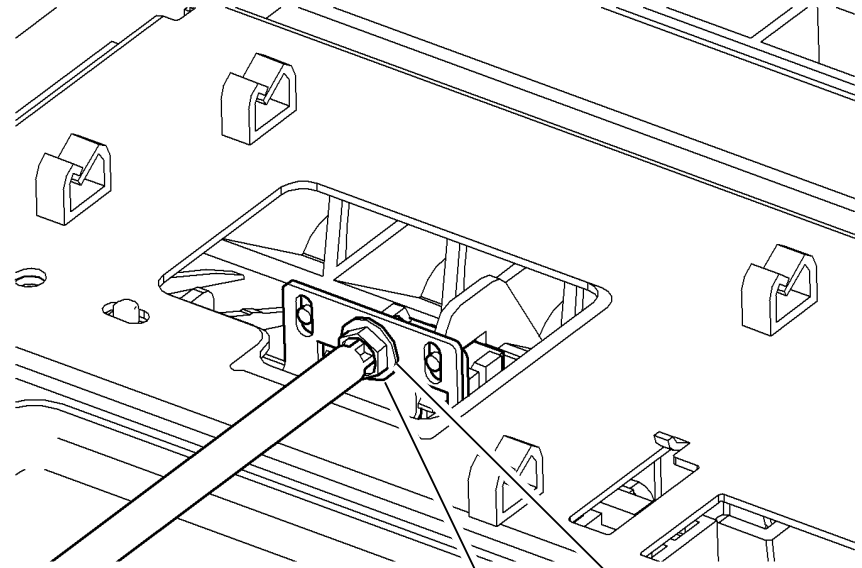
5. Adjust the position of the stack height sensor, [Figure 9](#).

- 2 Carefully reposition the sensor to the point where the display just changes from low to high.

- 1 Loosen the screw.

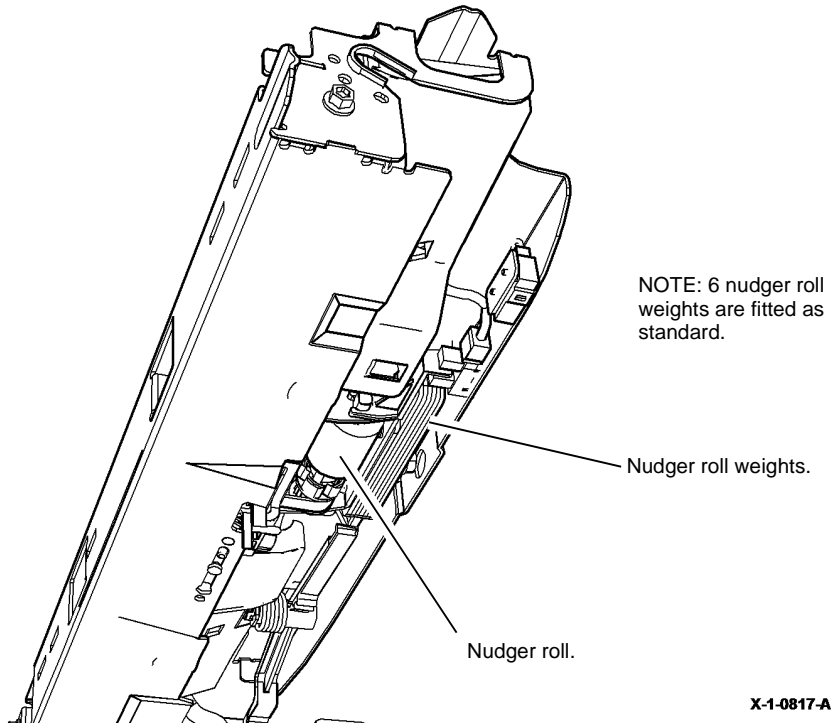
1. Remove the relevant paper feed assembly:
 - Tray 3, [REP 80.20](#).
 - Tray 4, [REP 80.21](#).
2. Check the number of nudger roll weights. Refer to [Figure 1](#).

Figure 1 Weights position

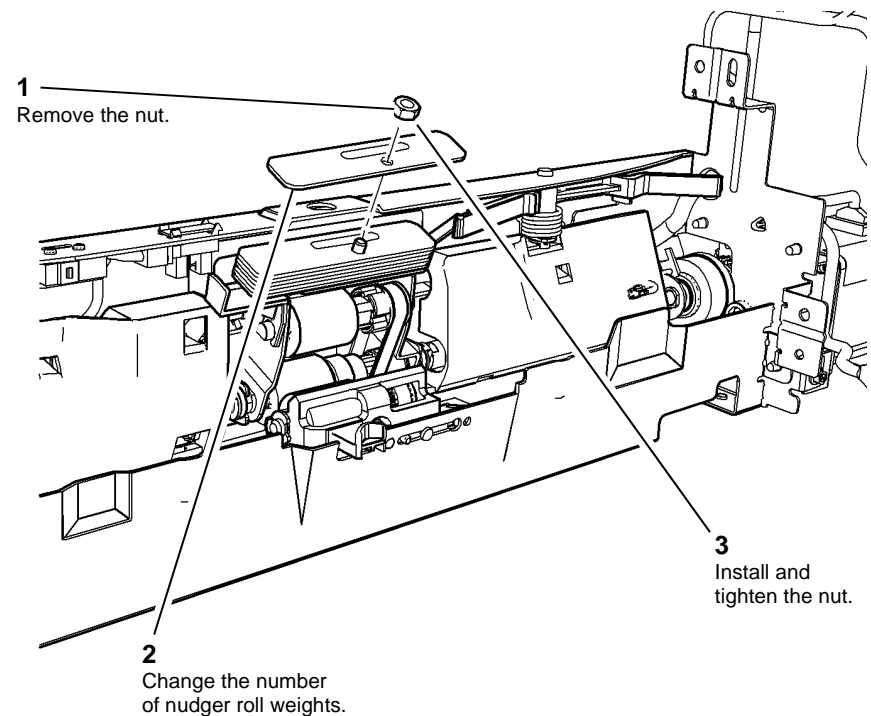
1. Change the number of nudger roll weights to adjust the downward pressure of the nudger roll, [Figure 2](#).

Figure 2 Spring seat adjustment

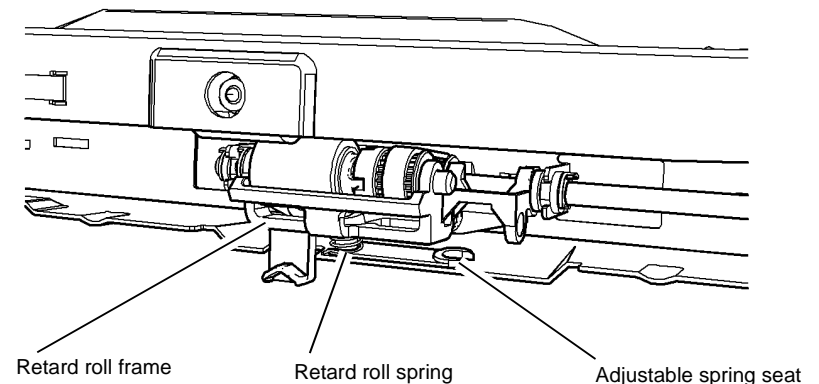
1. Remove the relevant paper feed assembly:
 - Tray 3, [REP 80.20](#).
 - Tray 4, [REP 80.21](#).
2. Check the position of the spring seat. Refer to [Figure 1](#).

Figure 1 Spring seat position

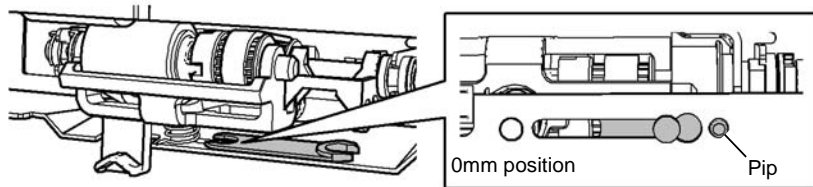
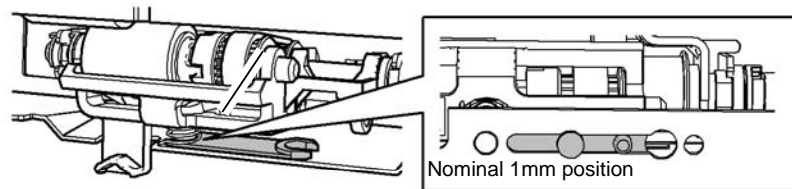
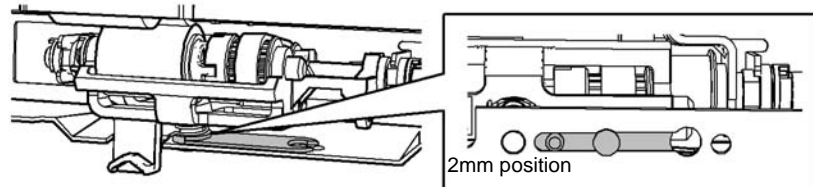
1. Change the position of the spring seat to adjust the nip pressure of the retard roll, [Figure 2](#):

- Change the spring seat to the 2mm position to increase the retard roll pressure.
- Change the spring seat to the 0mm position to decrease the retard roll pressure.

To release the spring seat from this position, press down the pip then slide the spring seat away from the frame hole.
To locate the spring seat in this position, slide the spring seat along the slot until the pip drops into the frame hole.

To release the spring seat from this position, lift up the base of the spring then slide the spring seat away from the spring position.
To locate the spring seat in this position, lift the base of the spring then slide the spring seat along the slot until the thin end is located under the spring.

To release the spring seat from this position, lift up the base of the spring then slide the spring seat away from the spring position.
To locate the spring seat in this position, lift the base of the spring then slide the spring seat along the slot until the thick end is located under the spring.

Figure 2 Spring seat adjustment

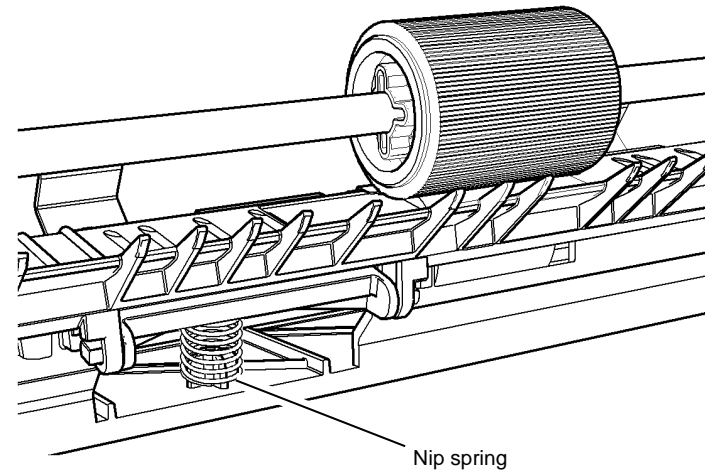
1. Insert a M10 washer, thickness 1.8mm, outside diameter 19.0mm (part number 251W10855 or 651W10855 - See Note) underneath the retard force nip spring, refer to [PL 70.35 Item 18](#) and [Figure 1](#) and [Figure 2](#).

Figure 1 Retard force nip spring

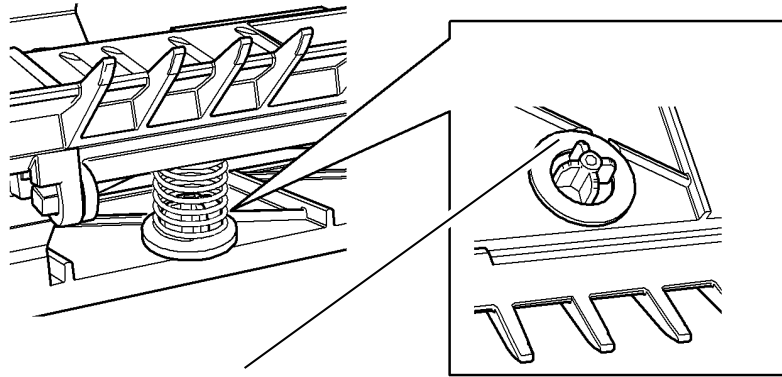
1
Ensure the washer is flat against the base of the bypass tray feeder frame. It may be necessary to remove part of a rib in the base.

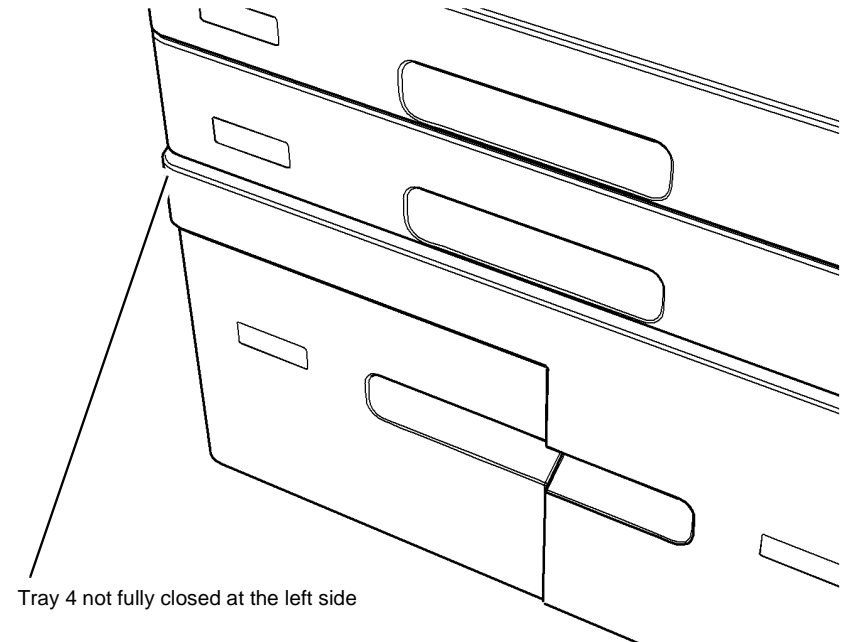
Open and close tray 4 several times to check that the tray closes easily and fully. [Figure 1](#), shows a tray 4 that is not fully closed at the left side. The tray is closed enough to actuate the tray home sensor, but paper jams, mis-feeds and skew can occur. If tray 4 does not close easily and/or fully, perform the adjustment.

Figure 1 Tray 4 not fully closed

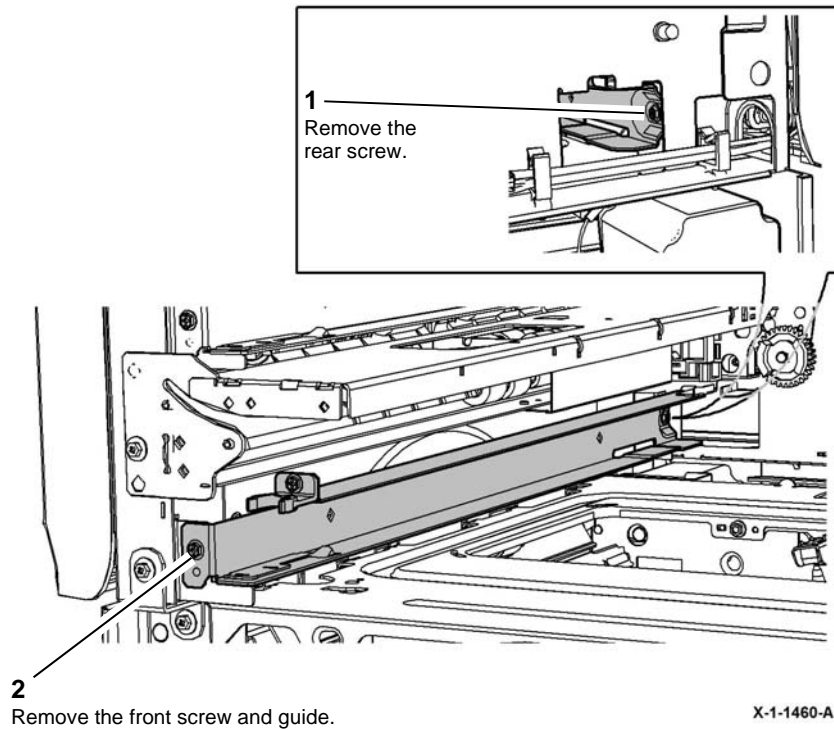
5. [Figure 2](#), remove the tray 2 left guide.

Figure 2 Left guide removal

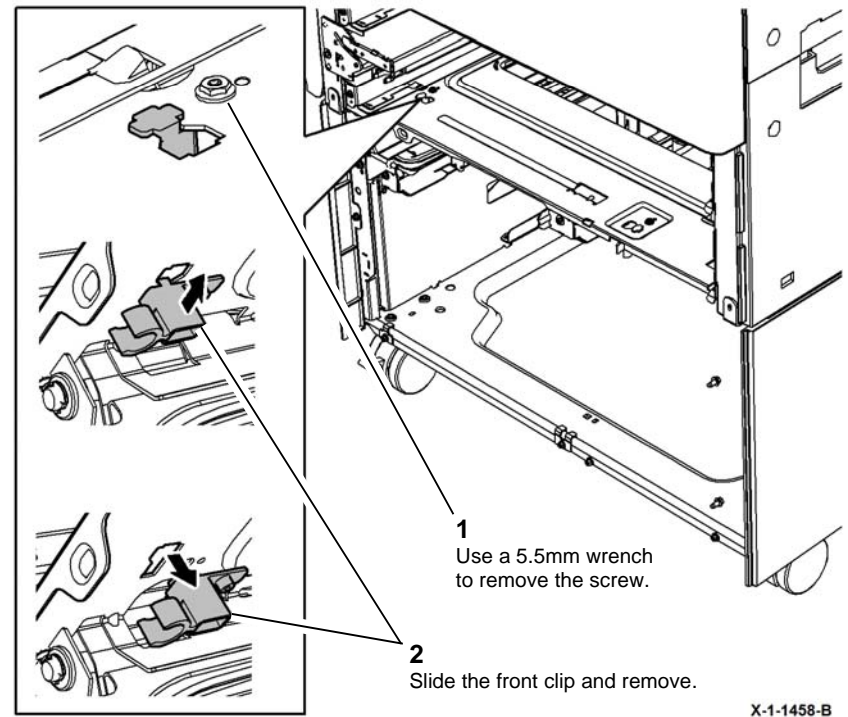
6. [Figure 3](#), remove the front clip.

NOTE: For clarity, tray 3 is not shown in [Figure 3](#).

Figure 3 Front clip removal

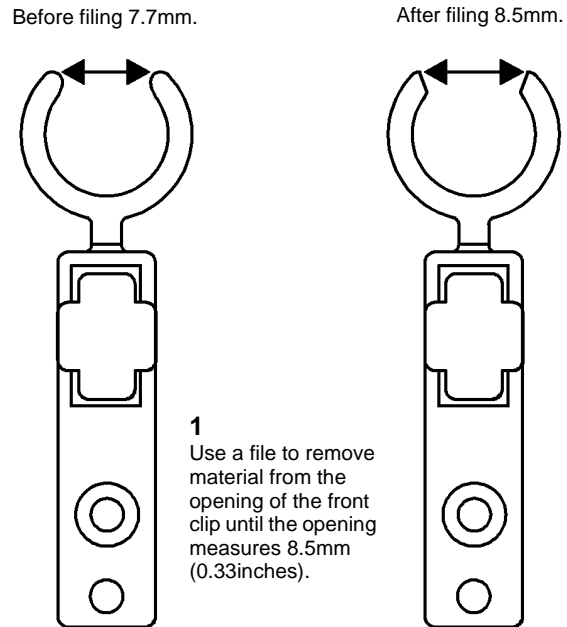
7. **Figure 4**, Adjust the opening of the front clip.

Figure 4 Front clip adjustment

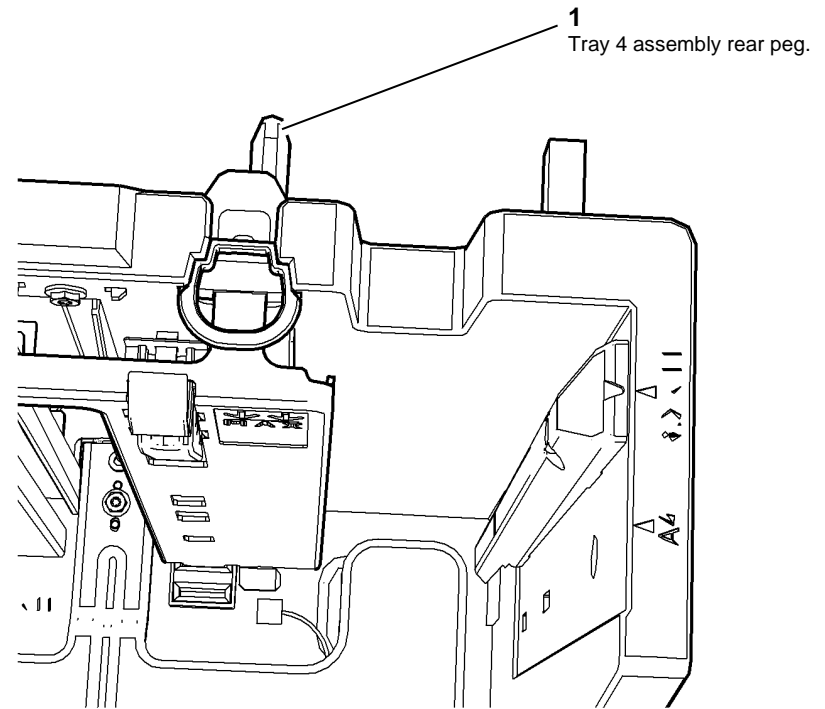
11. **Figure 5**, apply a thin coating of plastislip grease, **PL 26.10 Item 8** to the tray 4 assembly rear peg.

Figure 5 Tray 4 rear peg lubrication

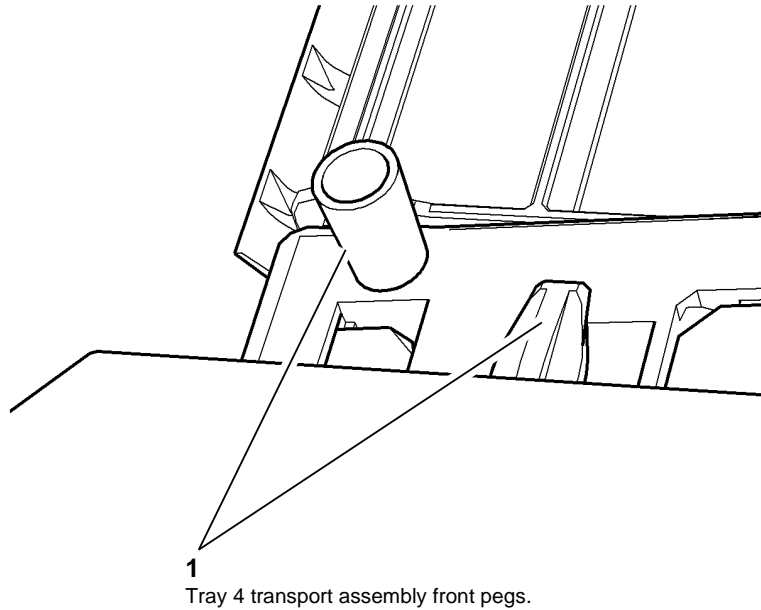
13. **Figure 6**, apply a thin coating of plastislip grease, **PL 26.10 Item 8** to the tray 4 transport assembly front pegs.

Figure 6 Front pegs lubrication

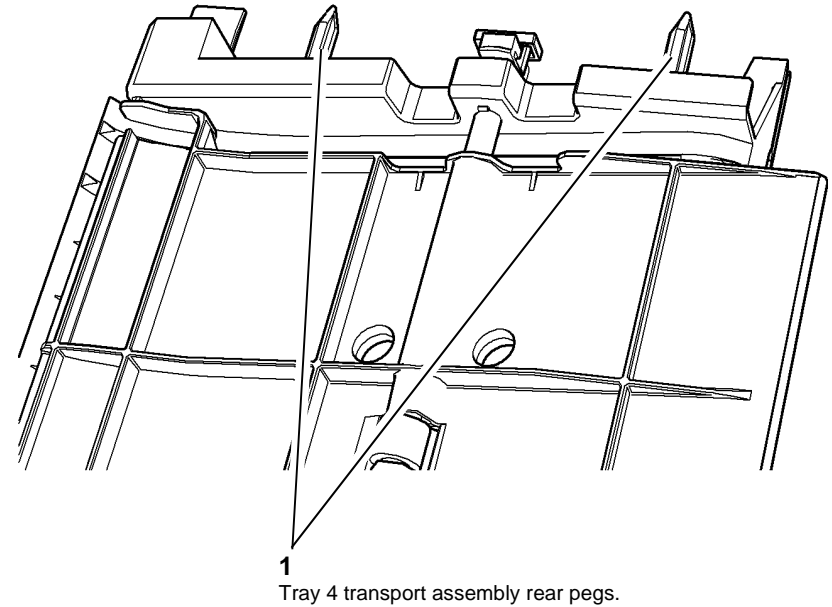
14. **Figure 7**, apply a thin coating of plastislip grease, **PL 26.10 Item 8** to the tray 4 transport assembly rear pegs.

Figure 7 Rear pegs lubrication

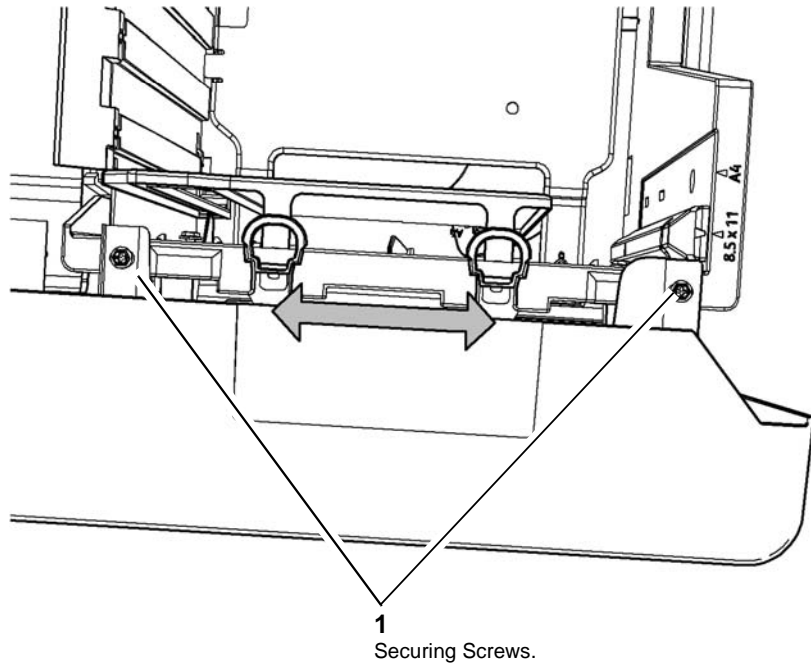
17. **Figure 8**, check that the tray 4 front cover will move to the left and right to allow the tray 4 transport assembly location pegs to align with the frame holes when the tray is closed. If necessary slightly loosen the two screws securing the tray 4 front cover to the tray 4 assembly until the front cover is free to move.

Figure 8 Cover left/right movement

15. Apply a thin coating of plastislip grease, **PL 26.10 Item 8** at the 2 fixing screw boss areas on the inside of the front cover and around the screw boss areas on the top of the tray 4 assembly, refer to **Figure 8**.
16. Re-install the tray 4 front cover, but do not overtighten the screws, refer to GP 6 Screw Usage.

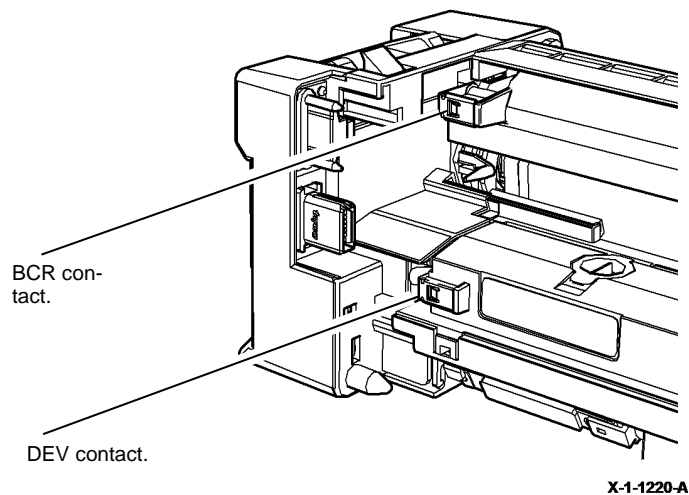
1. Remove the print cartridge, [PL 90.17 Item 9](#).
2. Use a lint free wiper, [PL 26.10 Item 13](#) dampened with cleaning fluid, [PL 26.10 Item 22](#) to clean the DEV and BCR contacts on the print cartridge, [Figure 1](#).

Figure 1 DEV and BCR contacts

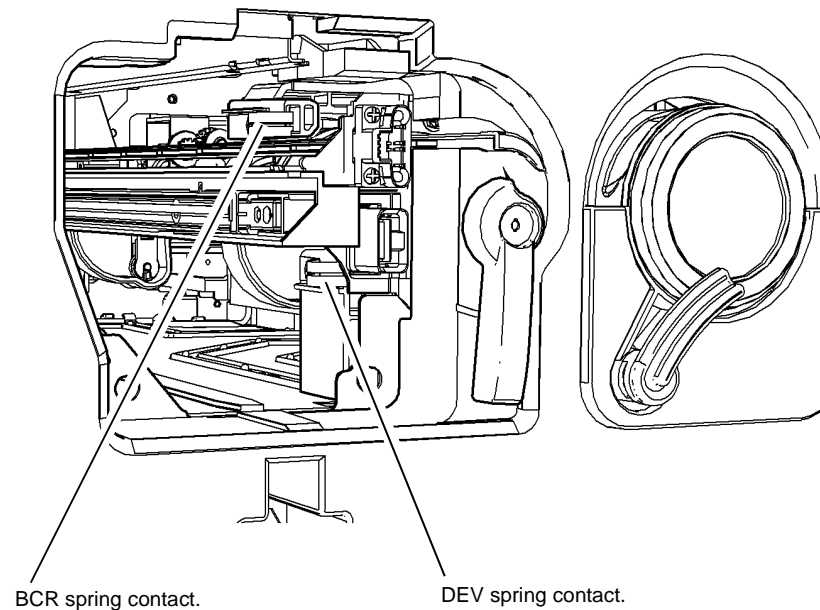
3. Place the print cartridge in a black bag.
4. Use a lint free wiper, [PL 26.10 Item 13](#) dampened with cleaning fluid, [PL 26.10 Item 22](#) to clean the DEV and BCR spring contacts, [Figure 2](#).

Figure 2 DEV and BCR spring contacts

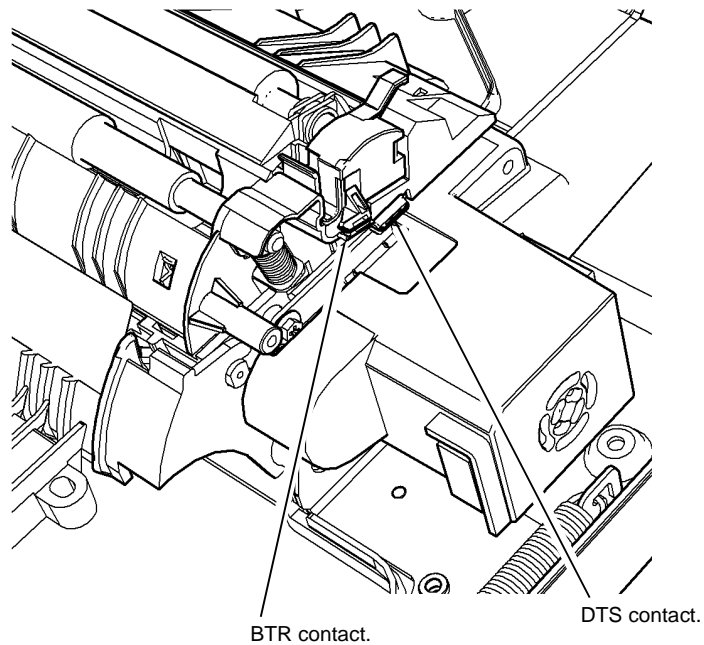
10. Use a lint free wiper, [PL 26.10 Item 13](#) dampened with cleaning fluid, [PL 26.10 Item 22](#) to clean the DTS and BTR contacts on the registration transfer assembly, [Figure 3](#).

Figure 3 DTS and BTR contacts

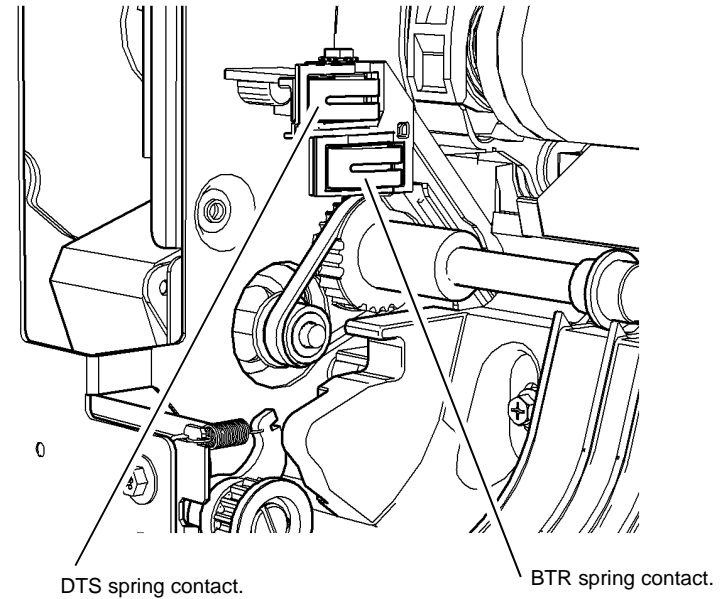
11. Use a lint free wiper, [PL 26.10 Item 13](#) dampened with cleaning fluid, [PL 26.10 Item 22](#) to clean the DTS and BTR spring contacts, [Figure 4](#).

Figure 4 DTS and BTR spring contacts

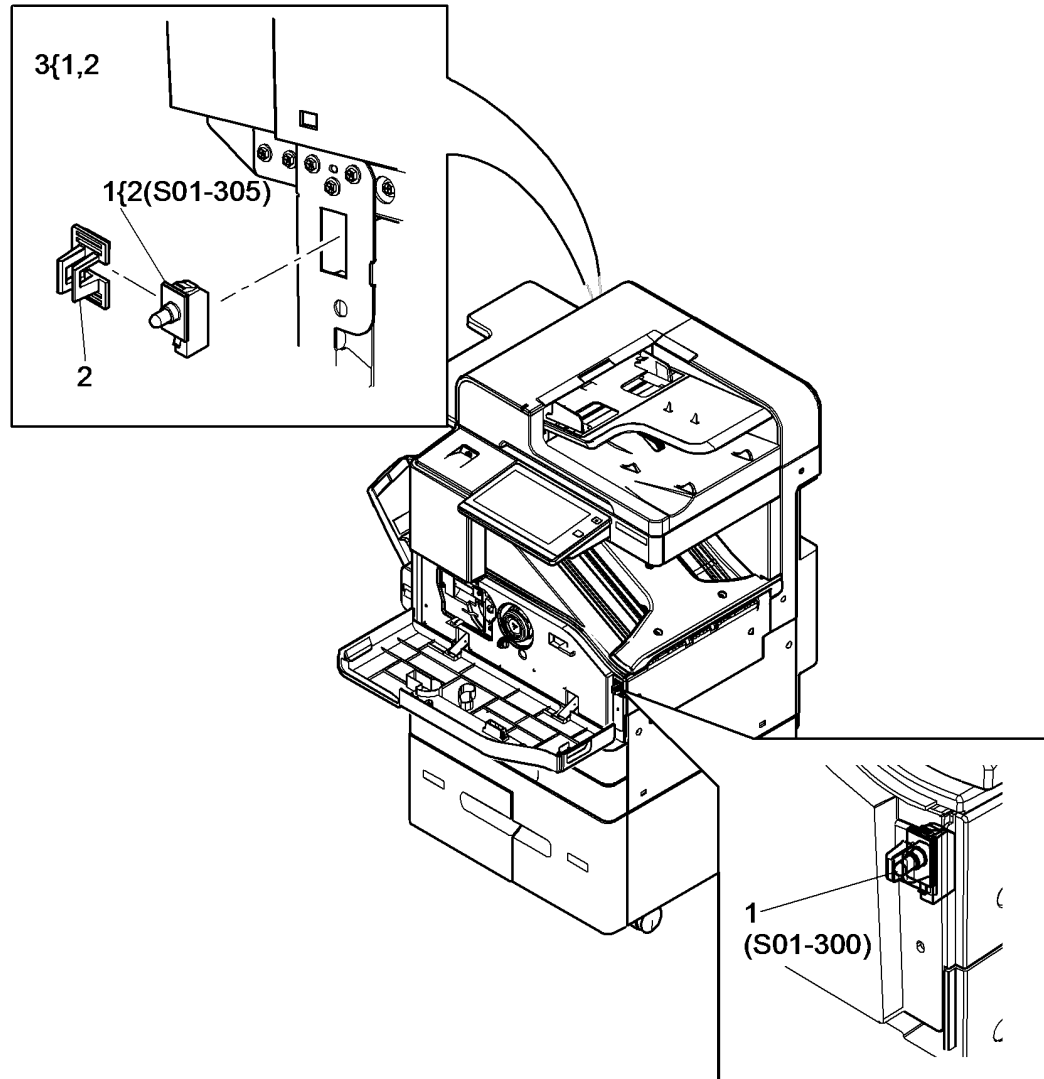
PL 1.12 Interlock Switches

Item	Part	Description
1	-	Front door interlock switch (S01-300) (REP 1.8)/ Left door interlock switch (S01-305) (REP 1.9) (P/O PL 1.12 Item 3)
2	-	Adapter (P/O PL 1.12 Item 3)
3	110K21900	Interlock switch assembly (REP 1.8)

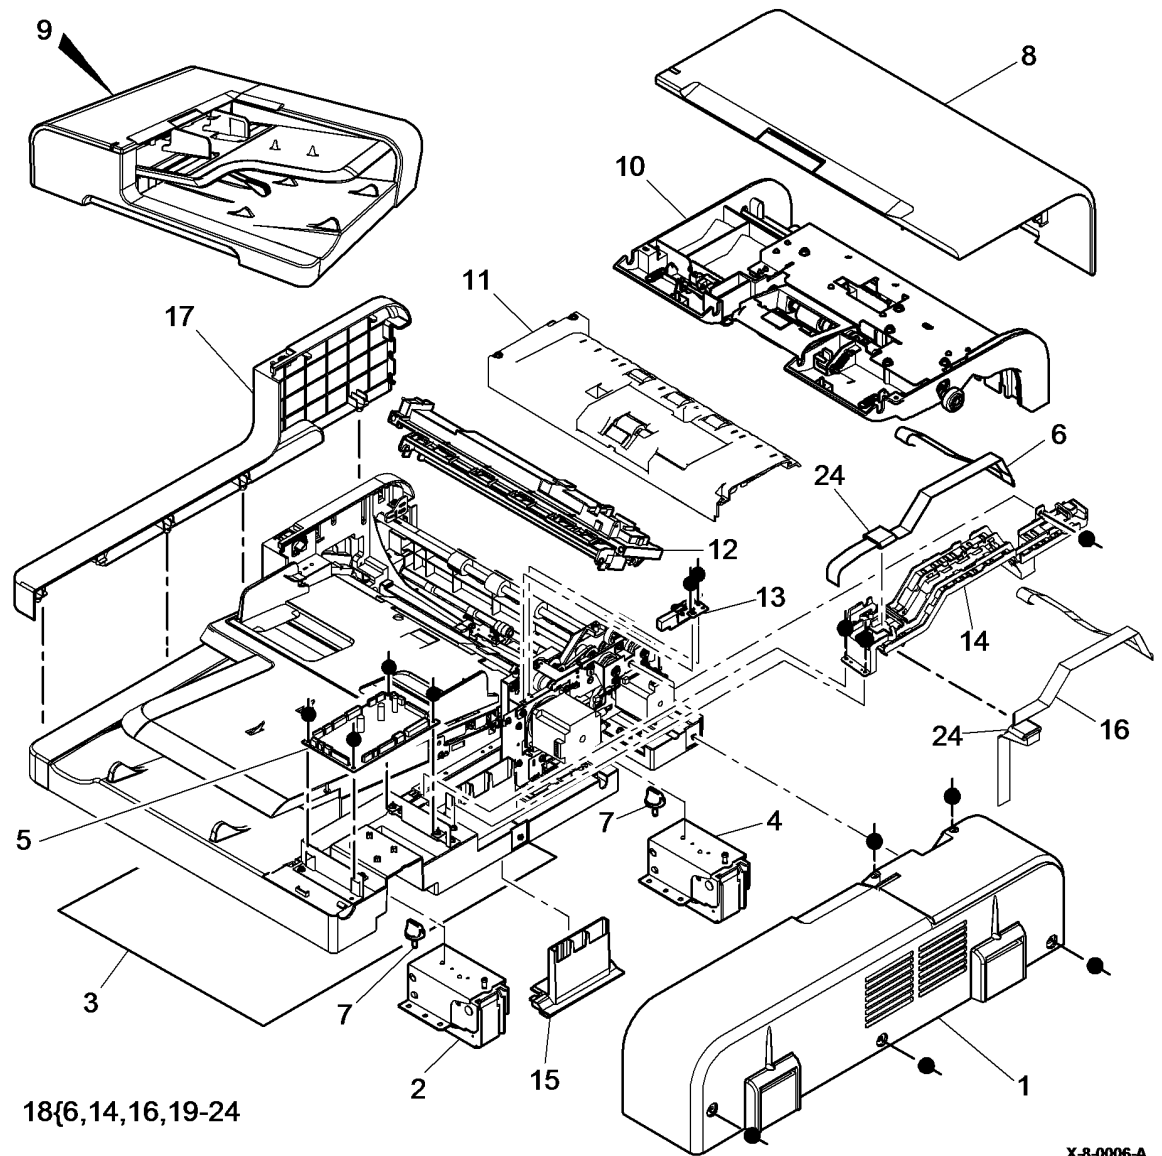
PL 5.10 SPDH (Complete), Covers, SPDH PWB

Item	Part	Description
1	948K29430	Rear cover
2	-	Right counterbalance (Not Spared) (ADJ 5.2, ADJ 5.3)
3	090E02690	Document pad
4	-	Left counterbalance (Not Spared) (ADJ 5.2, ADJ 5.3)
5	961K00060	SPDH PWB
6	-	Side 2 scan assembly power ribbon cable (P/O PL 5.10 Item 18) (REP 5.19)
7	826E85400	Thumbscrew
8	-	Top cover (REF: PL 5.20)
9	084K43040	SPDH (complete) (REP 5.18)
10	-	Feed assembly (REF: PL 5.20) (ADJ 5.3)
11	-	Separation assembly (REF: PL 5.25)
12	-	Side 2 scan assembly (REF: PL 60.30)
13	-	Top cover interlock switch (S05-305)(Not Spared)
14	-	Harness support (P/O PL 5.10 Item 18)
15	-	Harness guide (Not Spared)
16	-	Side 2 scan assembly data ribbon cable (P/O PL 5.10 Item 18) (REP 5.19)
17	948K29420	Front cover
18	952K60490	SPDH FFC harness assembly (REP 5.20)
19	-	Takeaway clutch harness (Not shown) (P/O PL 5.10 Item 18)
20	-	Feed clutch harness (Not shown) (P/O PL 5.10 Item 18)
21	-	Reg sensor harness (Not shown) (P/O PL 5.10 Item 18)

22	-	Feed motor harness (Not shown) (P/O PL 5.10 Item 18)
23	-	Read motor harness (Not shown) (P/O PL 5.10 Item 18)
24	-	Ferrite (P/O PL 5.10 Item 18)
25	-	Feed sensor harness (P/O PL 5.10 Item 18)

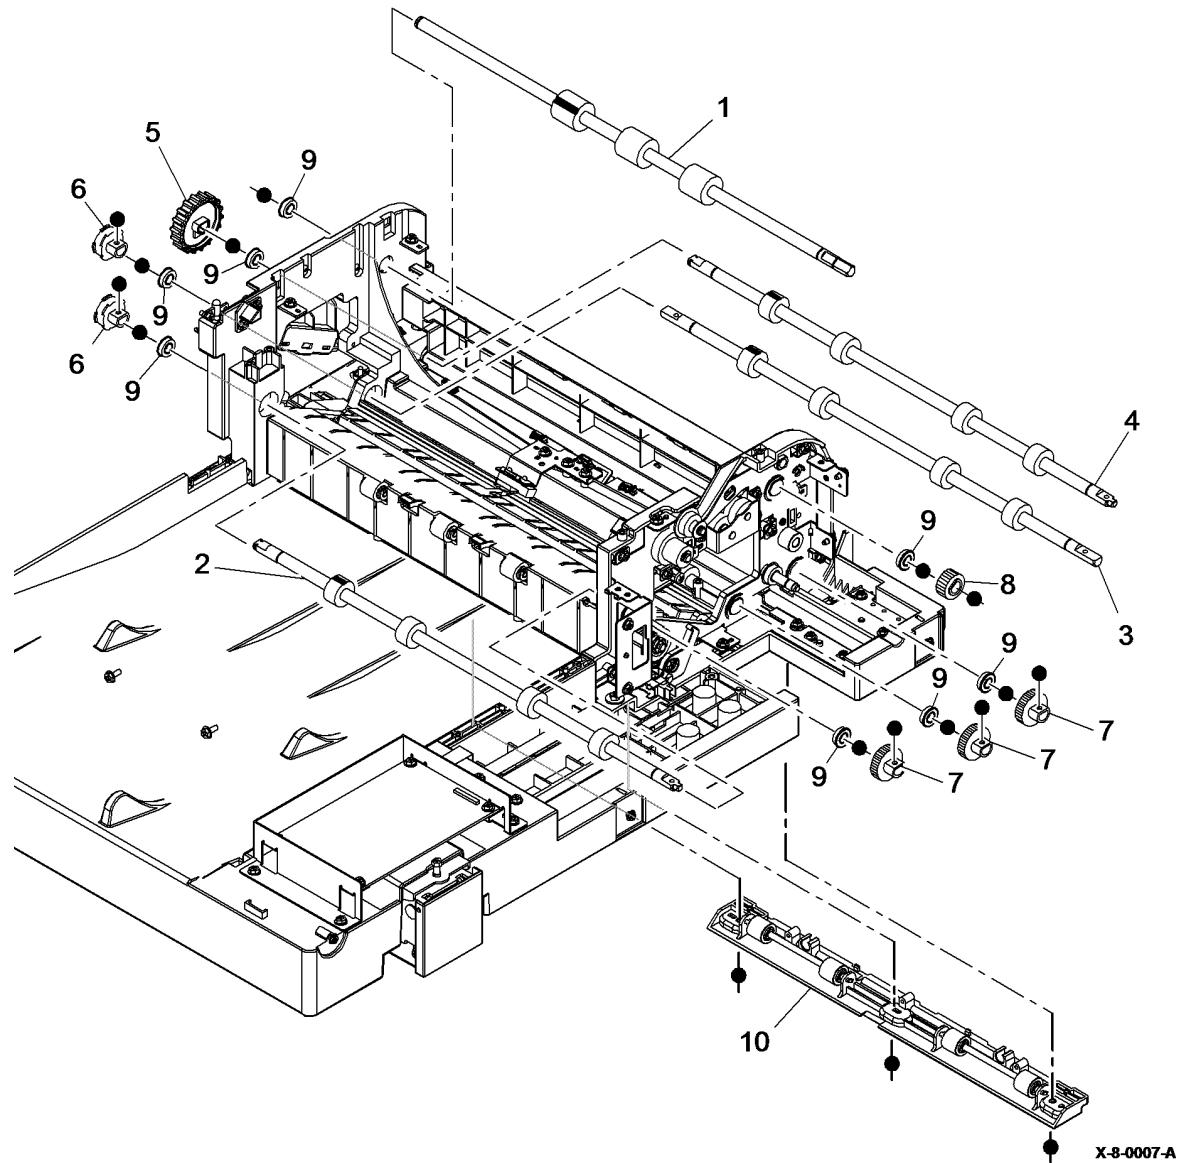
PL 5.17 SPDH Transport Assembly

Item	Part	Description
1	859K17110	Takeaway roll assembly (REP 5.5)
2	859K17140	Exit roll assembly (REP 5.7)
3	859K17130	Mid scan roll assembly (REP 5.16)
4	859K17120	Pre scan roll assembly (REP 5.17)
5	–	Exit jam clearance knob (Not Spared)
6	–	Idler gear (Not Spared)
7	–	Drive gear (Not Spared)
8	–	Gear (Not Spared)
9	–	Bearing (Not Spared)
10	859K17150	Lower pre scan roll assembly (REP 5.6)

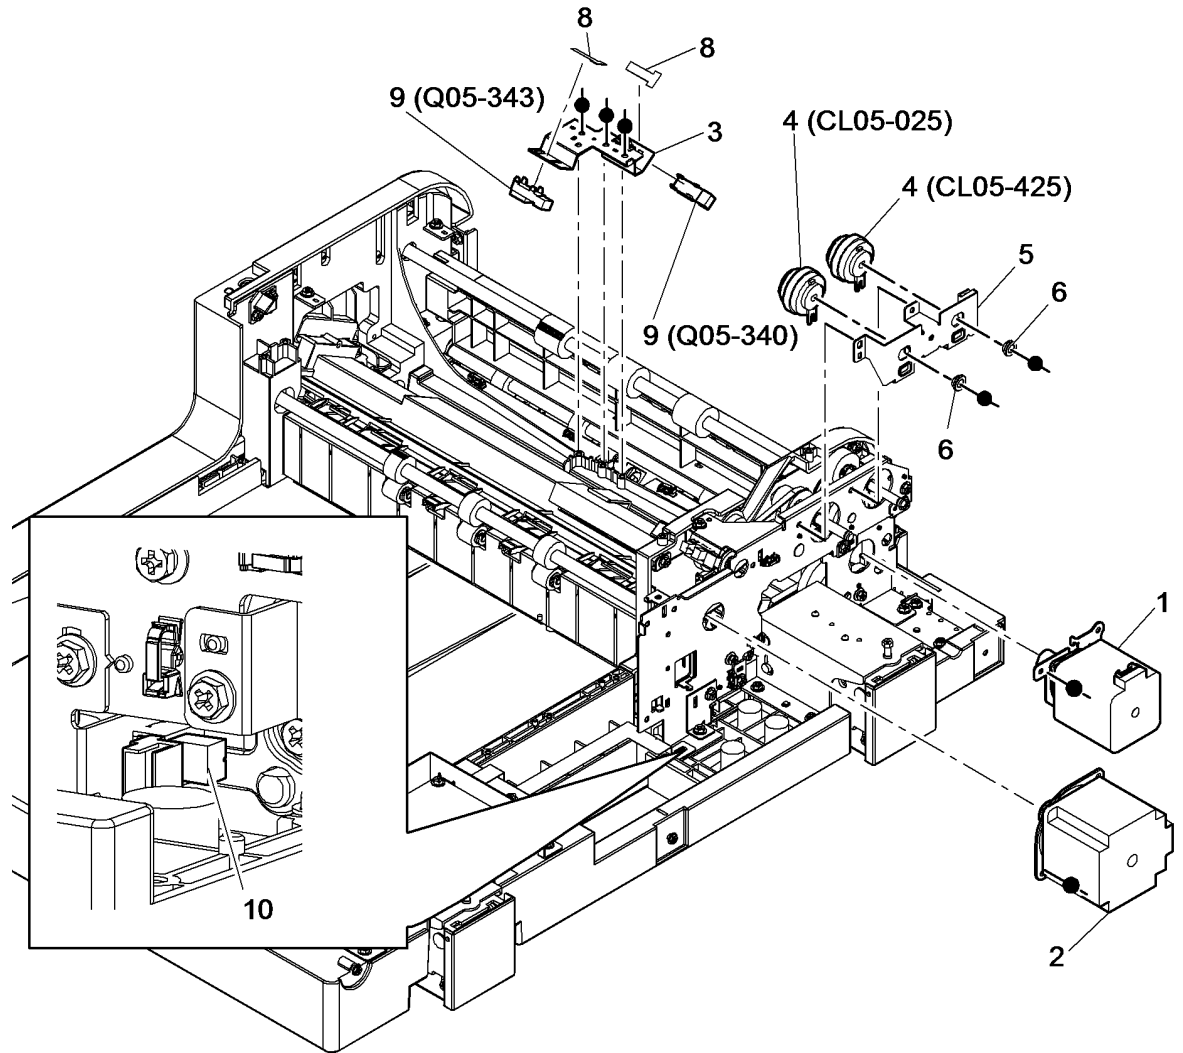
PL 5.18 SPDH Drive Assembly

Item	Part	Description
1	127E18080	Read motor (MOT05-030) (REP 5.13)
2	127E18070	Feed motor (MOT05-020) (REP 5.12)
3	–	Sensor bracket (Not Spared)
4	005E44410	Feed clutch (CL05-025)/Takeaway clutch (CL05-425) (REP 5.14)
5	–	Bracket (Not Spared)
6	–	Bearing (Not Spared)
7	–	Not used
8	–	Sensor shim (Not Spared)
9	–	Side 2 Reg sensor (Q05-343) (REP 60.13)/Reg sensor (Q05-340) (REP 5.10)
10	–	Calibration home position sensor (Q05-360) (REP 5.11)

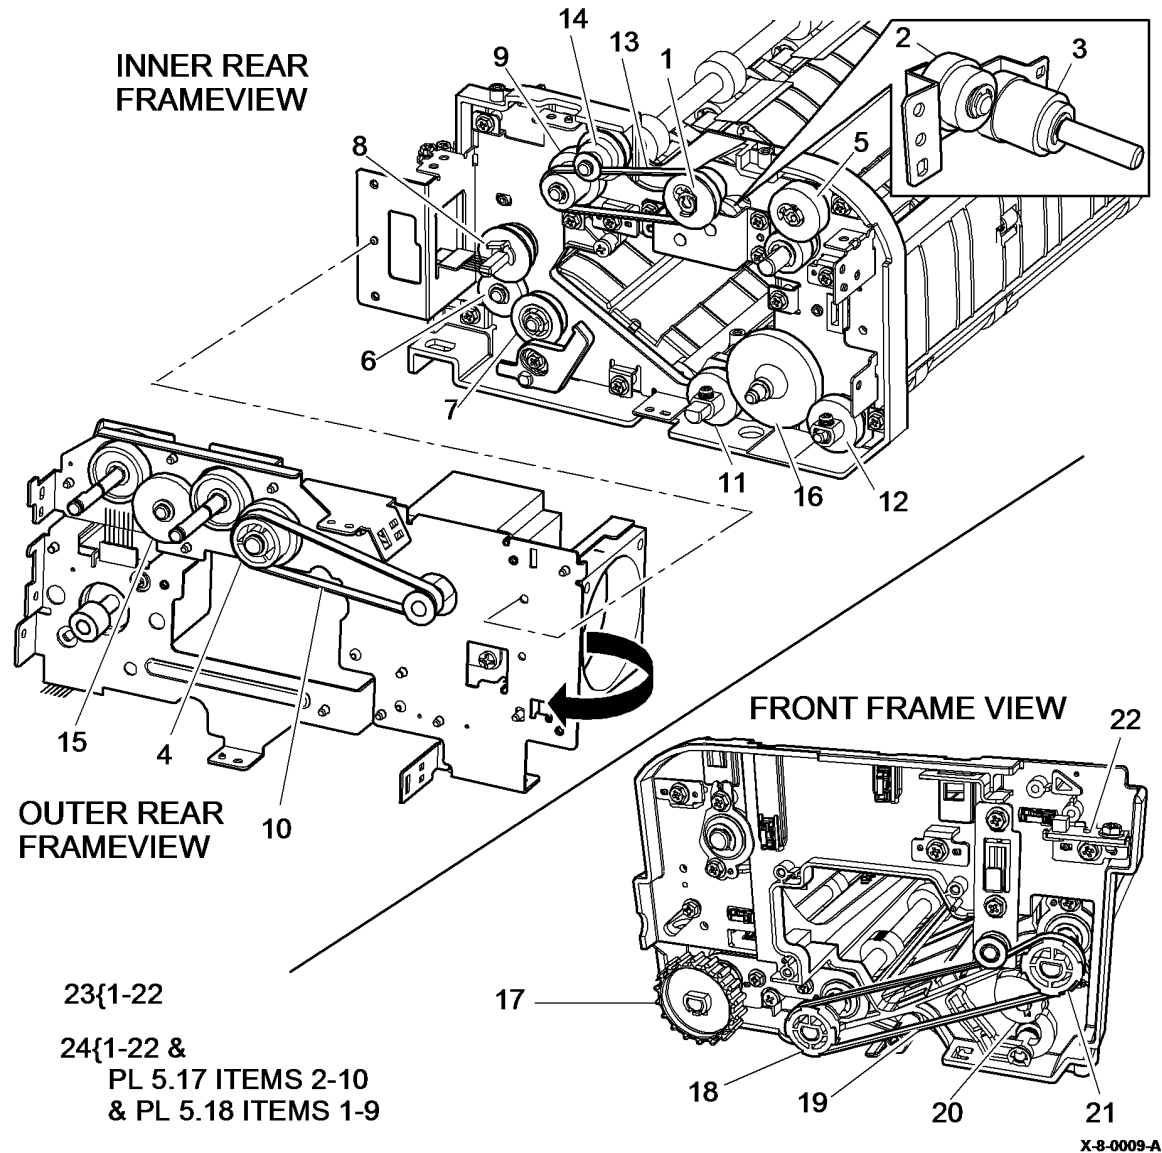
PL 5.19 SPDH Read Assembly

Item	Part	Description
1	-	Retard roll intermediate drive gear/ pulley (P/O PL 5.19 Item 23)
2	-	Retard roll driven gear (P/O PL 5.19 Item 23)
3	-	Retard roll drive gear (P/O PL 5.19 Item 23)
4	-	Feed clutch drive gear/pulley (P/O PL 5.19 Item 23)
5	-	Takeaway roll drive gear (P/O PL 5.19 Item 23)
6	-	Calibration shutter idler gear/TAR clutch drive gear (P/O PL 5.19 Item 23)
7	-	Calibration shutter driven gear (P/O PL 5.19 Item 23)
8	-	Calibration shutter drive gear (P/O PL 5.19 Item 23)
9	-	Feed assembly drive gear /pulley (P/O PL 5.19 Item 23)
10	-	Feed motor belt (P/O PL 5.19 Item 23) (REP 5.12)
11	-	Pre-scan roll drive gear (P/O PL 5.19 Item 23)
12	-	Mid scan drive gear (P/O PL 5.19 Item 23)
13	-	Feed assembly drive belt (P/O PL 5.19 Item 23)
14	-	Feed assembly idler gear (P/O PL 5.19 Item 23)
15	-	Takeaway idler gear (P/O PL 5.19 Item 23)
16	-	Read motor idler gear (P/O PL 5.19 Item 23)
17	-	Exit jam clearance knob (P/O PL 5.19 Item 23)

18	-	Pre-scan roll pulley (P/O PL 5.19 Item 23)
19	-	Exit roll drive belt (P/O PL 5.19 Item 23)
20	-	Front calibration cam (P/O PL 5.19 Item 23)
21	-	Exit roll pulley (P/O PL 5.19 Item 23)
22	961K00070	Doc present LED PWB
23	-	SPDH drive kit (See NOTE)
24	007K27150	Read assembly (REP 5.20)
