708P91368
September 2017

Xerox® AltaLink® B8090 Family Multifunction Printer Service Manual

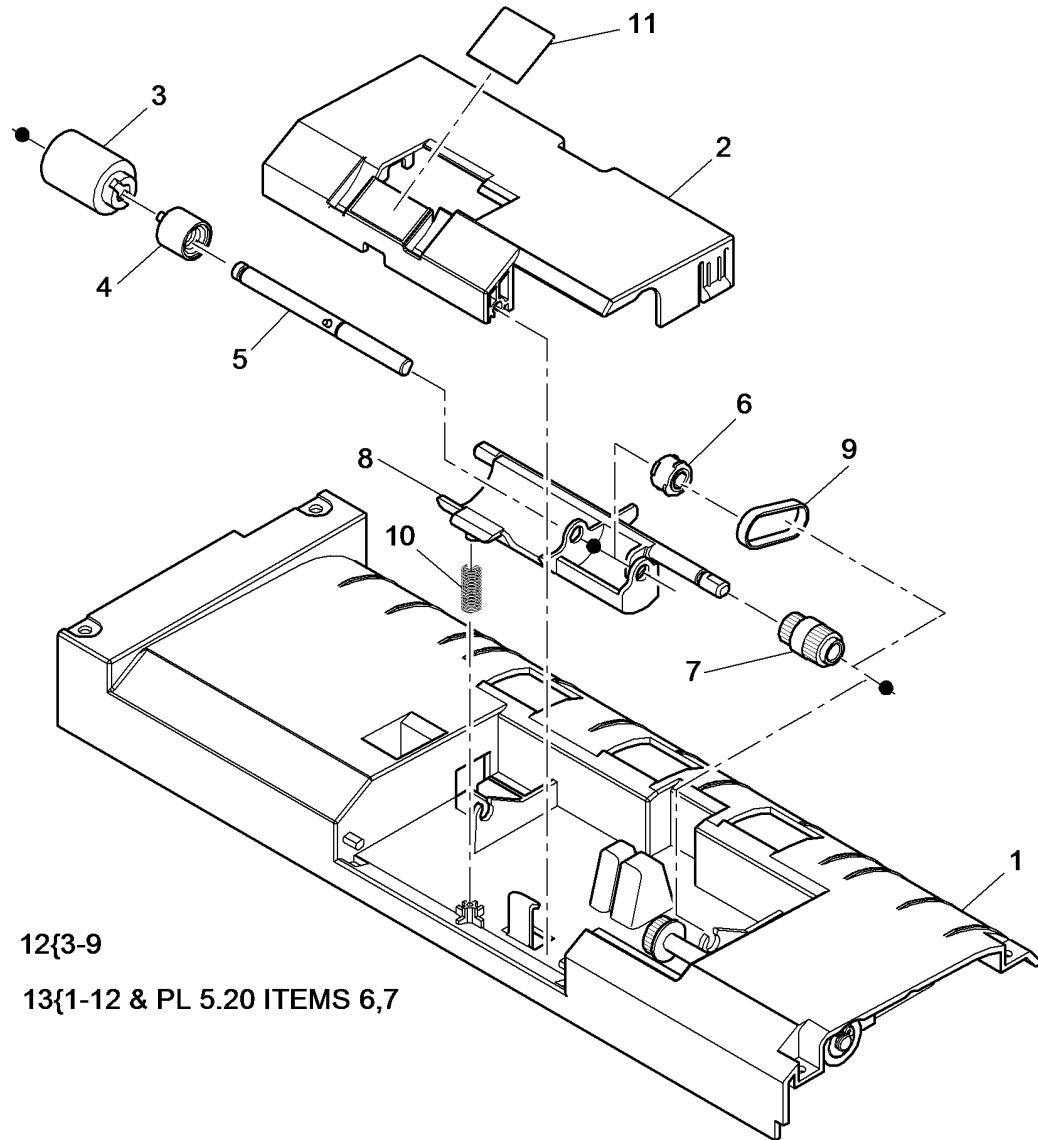
PL 5.25 SPDH Separation Assembly

Item	Part	Description
1	-	Separation frame (P/O PL 5.25 Item 13)
2	-	Retard roll cover (P/O PL 5.25 Item 13)
3	-	Retard roll (P/O PL 5.25 Item 12) (See NOTE 1 & 2) (REP 5.3)
4	-	Coupling (P/O PL 5.25 Item 12)
5	-	Shaft (P/O PL 5.25 Item 12)
6	-	Pulley (P/O PL 5.25 Item 12)
7	-	Drive gear (P/O PL 5.25 Item 12) (REP 5.3)
8	-	Retard roll housing (P/O PL 5.25 Item 12)
9	-	Belt (P/O PL 5.25 Item 12)
10	-	Spring (Not Spared)
11	-	Mylar guide (P/O PL 5.25 Item 2)
12	-	Retard roll assembly (P/O PL 5.25 Item 13) (REP 5.3)
13	-	Separation assembly (Not Spared) (REP 5.3)

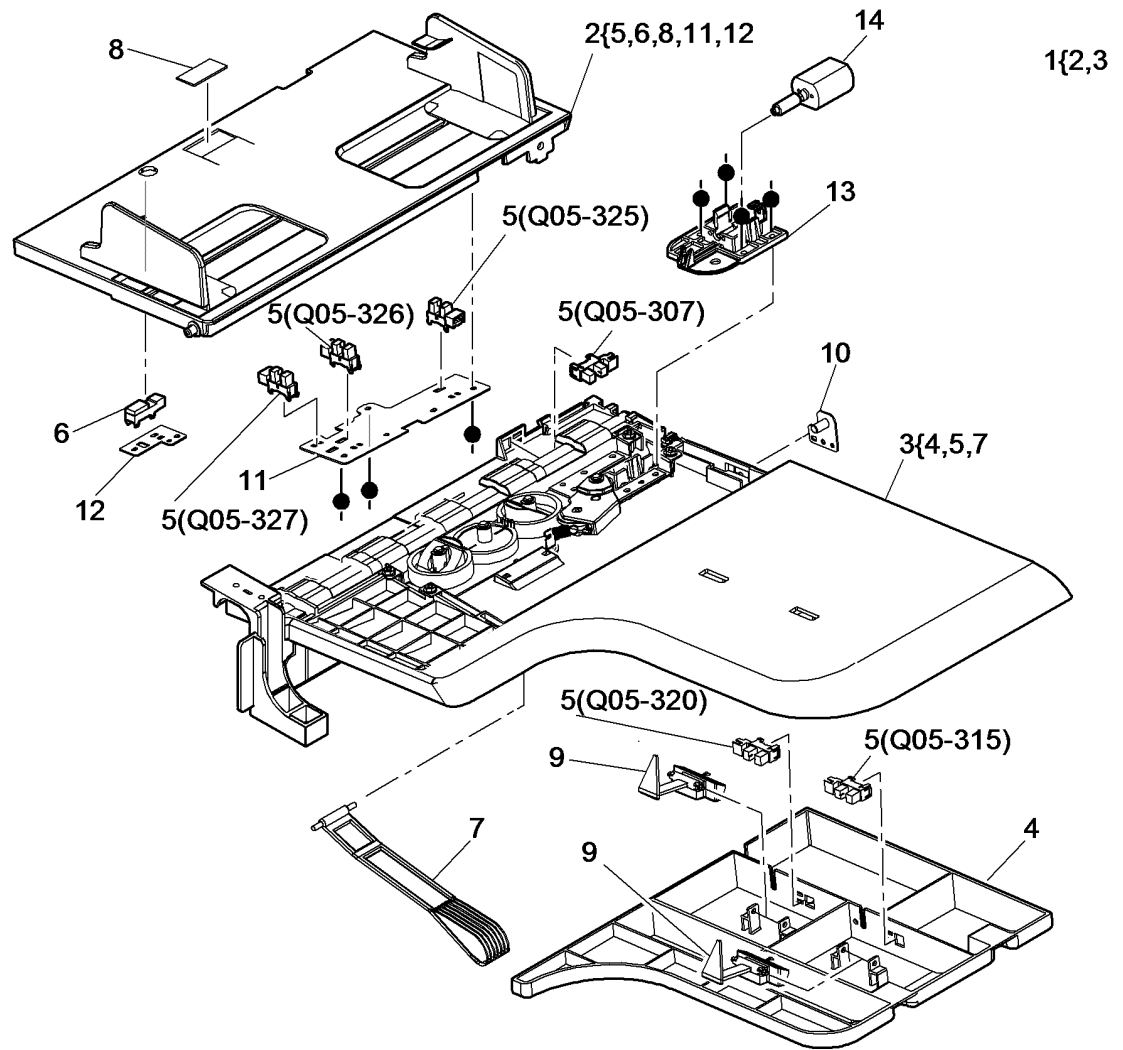
PL 5.30 Input Tray Assembly

Item	Part	Description
1	850K03070	Input tray assembly (complete) (REP 5.23)
2	-	Tray upper assembly (P/O PL 31.14 Item 11) (REP 5.4)
3	-	Tray lower assembly (P/O PL 5.30 Item 1) (REP 5.4)
4	-	Tray lower cover (P/O PL 5.30 Item 3)
5	-	Length sensor 1 (Q05-315) (REP 5.9)/Length sensor 2 (Q05-320) (REP 5.9)/Lift home position sensor (Q05-307) (REP 5.4)/Width sensor 1 (Q05-325) (REP 5.15)/Width sensor 2 (Q05-326) (REP 5.15)/Width sensor 3 (Q05-327) (REP 5.15)
6	-	Doc present sensor (Q05-309) (REP 5.15)
7	-	Restack arm (P/O PL 5.30 Item 1)
8	819E27740	Retard pad
9	-	Length sensor 1 actuator (P/O PL 5.30 Item 3)
10	-	Tray upper hinge (Not Spared) (REP 5.4)
11	-	Sensor mounting plate (P/O PL 5.30 Item 2)
12	-	Sensor mounting bracket (P/O PL 5.30 Item 2)
13	-	Elevator tray motor mounting bracket (P/O PL 5.30 Item 1)
14	127E18090	Elevator tray motor (MOT05-390) (REP 5.21)

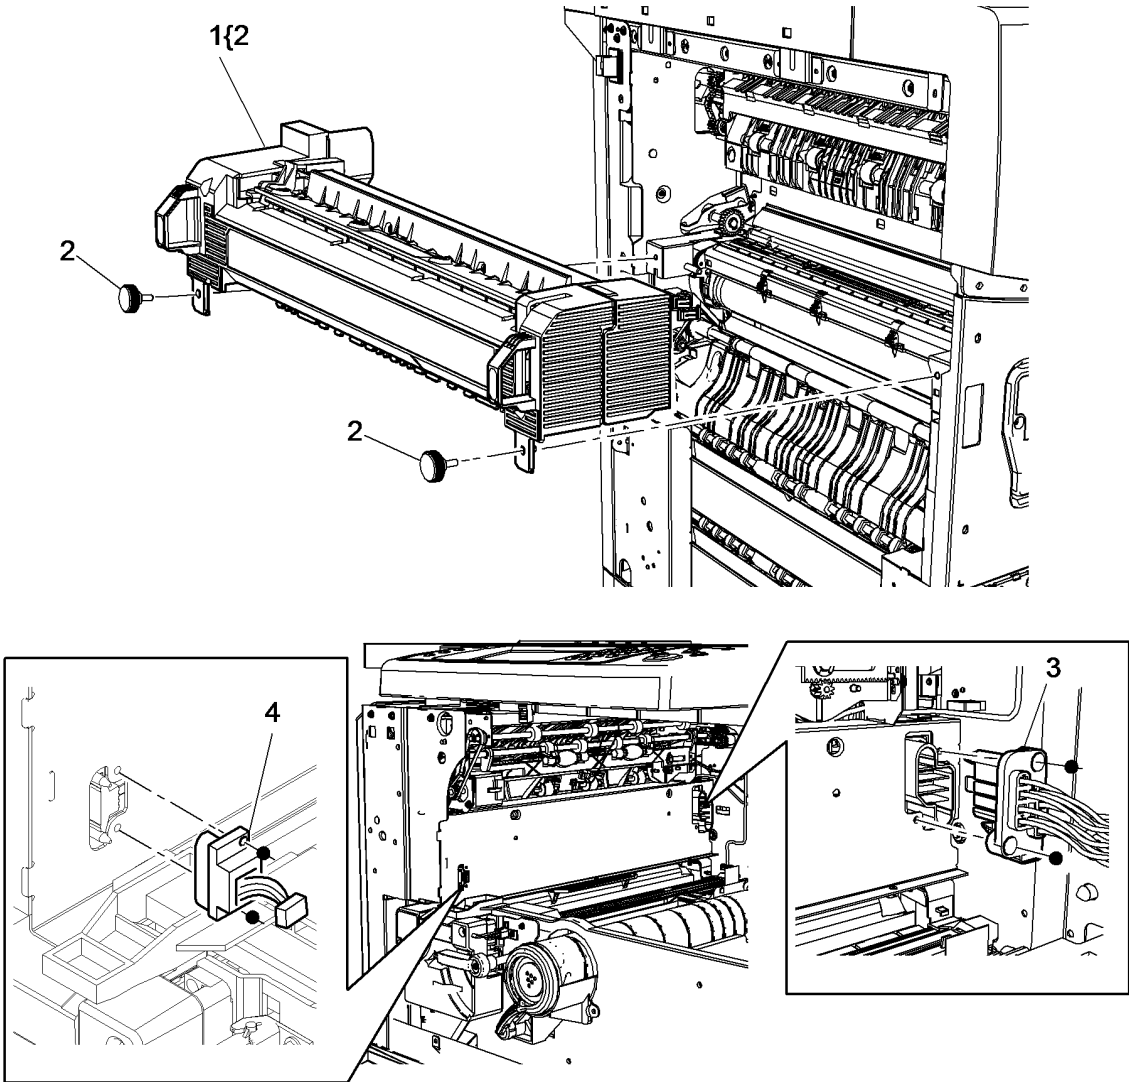
PL 10.8 Fuser Module

Item	Part	Description
1	109R00848	Fuser module (50Hz) (45-55 ppm)
-	109R00849	Fuser (50Hz) (65-90 ppm)
-	109R00847	Fuser module (60Hz) (45-55 ppm)
-	109R00850	Fuser (60Hz) (65-90 ppm)
2	-	Thumbscrew (P/O PL 10.8 Item 1)
3	-	Fuser connector (Not Spared)
4	-	Fuser CRUM (Not Spared)

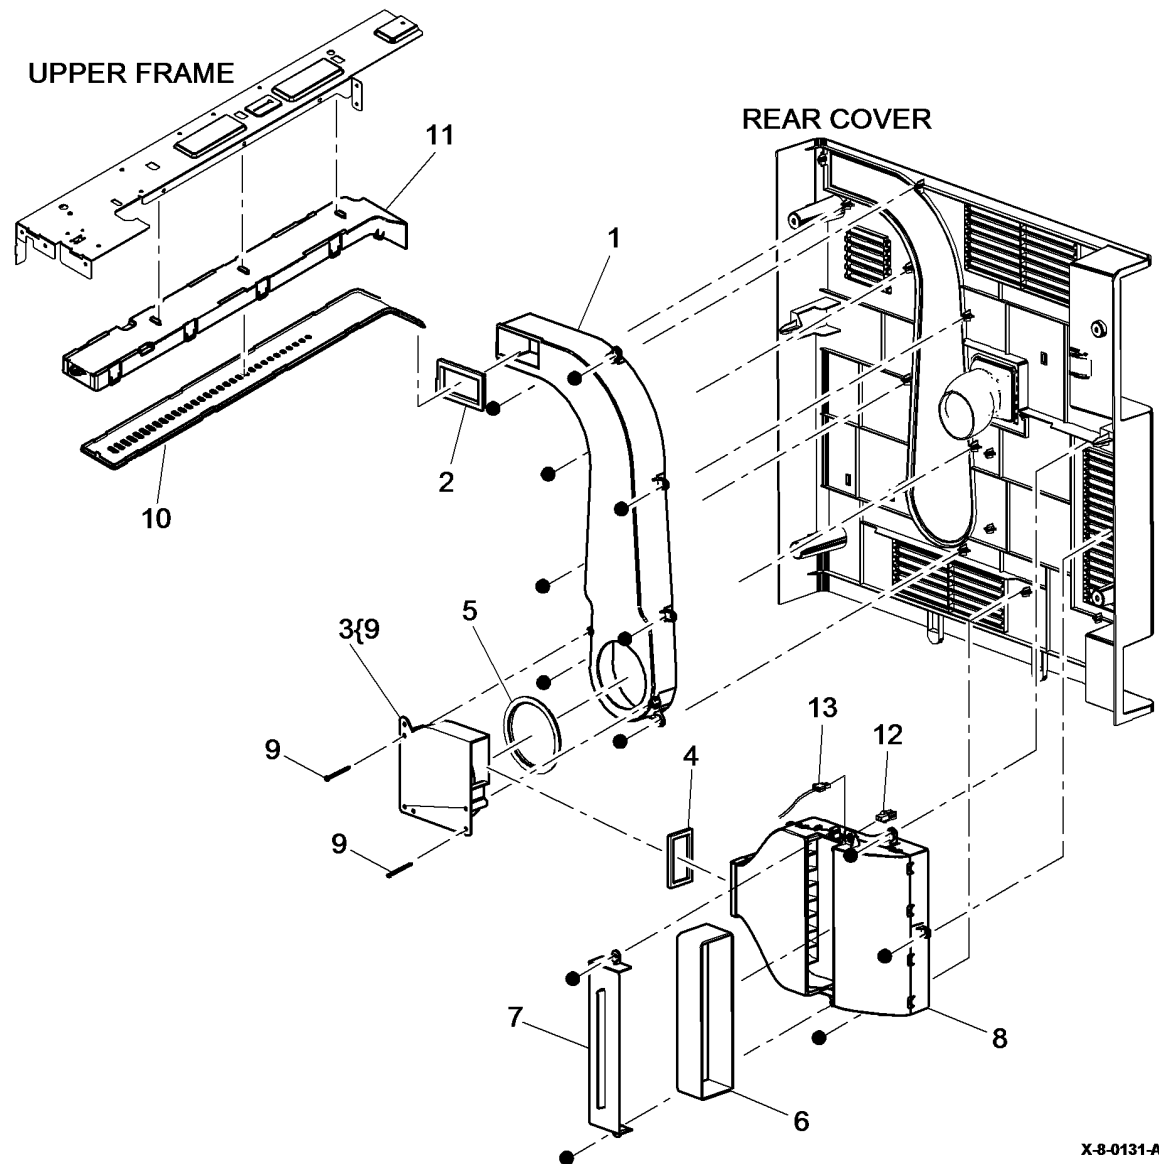
PL 10.9 Fuser Module Cooling (65-90 ppm)

Item	Part	Description
1	-	Inner duct cover (P/O PL 28.10 Item 1)
2	-	Rear cover gasket (P/O PL 28.10 Item 1)
3	-	Rear exit fan (P/O PL 28.10 Item 1)
4	-	Exit fan duct gasket (P/O PL 28.10 Item 1)
5	-	Rear exit fan gasket (P/O PL 28.10 Item 1)
6	053E09320	Filter
7	-	Filter cover (P/O PL 28.10 Item 1)
8	-	Exit fan duct assembly (P/O PL 28.10 Item 1)
9	-	Securing screw (P/O PL 10.9 Item 3)
10	-	Lower duct cover (P/O PL 28.10 Item 1)
11	-	Upper duct cover (P/O PL 28.10 Item 1)
12	-	Temperature sensor (P/O PL 28.10 Item 1)
13	-	Sensor harness (Not Spared)

NOTE: All of these items are part of the 65-90 ppm rear cover assembly, PL 28.10 Item 1.

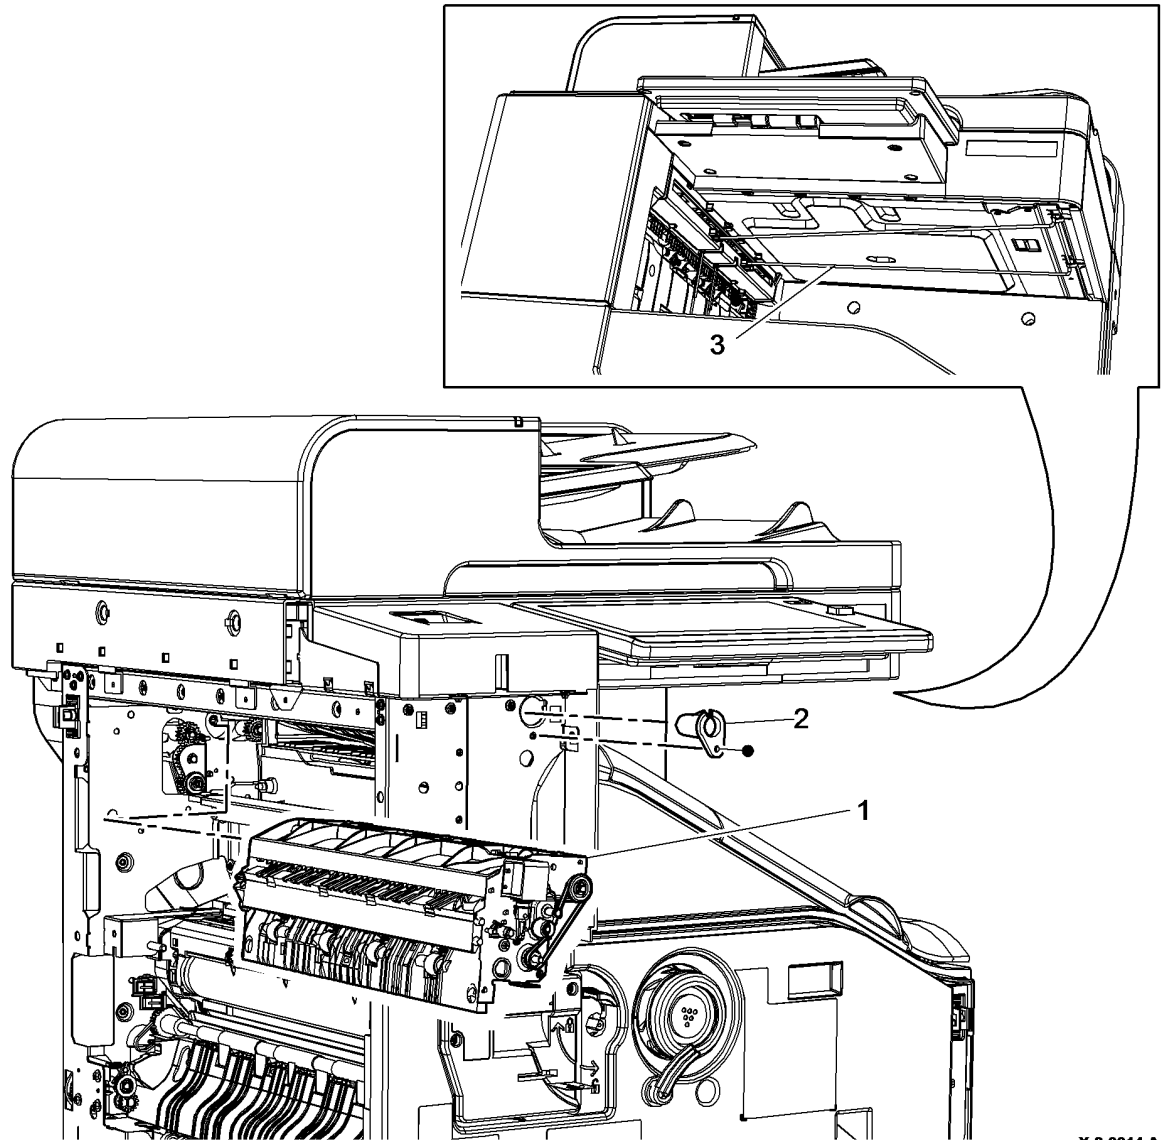
PL 10.10 Inverter Assembly (1 of 3)

Item	Part	Description
1	-	Inverter assembly (REF: PL 10.11, PL 10.13) (REP 10.1)
2	-	Inverter locator (Not Spared) (REP 10.1)
3	-	Diverter output guide (Not Spared)

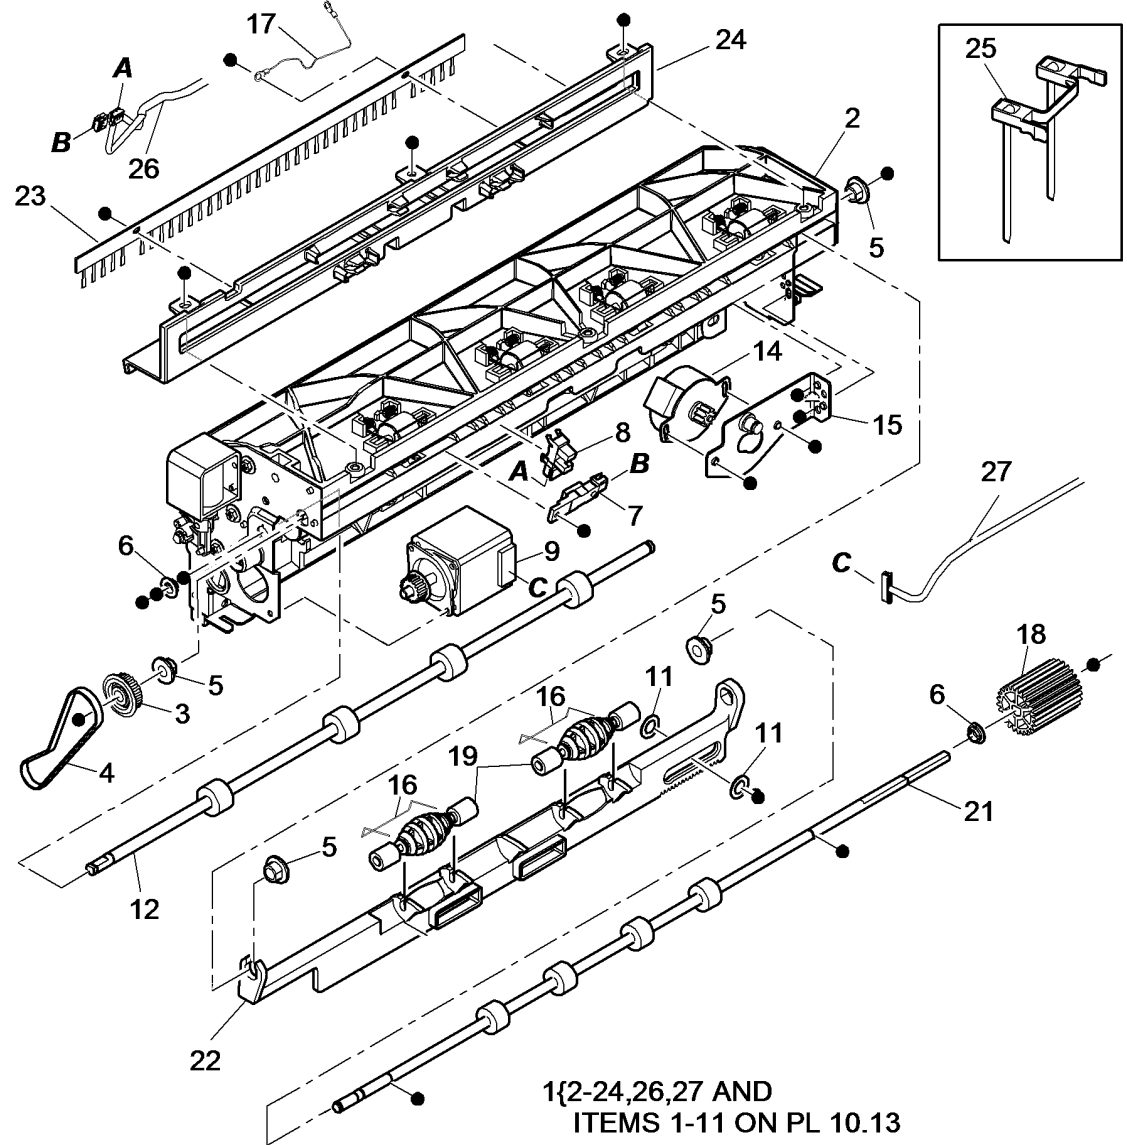
PL 10.11 Inverter Assembly (2 of 3)

Item	Part	Description
1	112K01341	Inverter assembly (REP 10.1)
2	-	Exit guide housing (P/O PL 10.11 Item 1)
3	-	Pulley (21T) (P/O PL 10.11 Item 1)
4	-	Drive belt (P/O PL 10.11 Item 1)
5	-	Bearing (P/O PL 10.11 Item 1) (REP 10.5)
6	-	Shaft bearing (P/O PL 10.11 Item 1) (REP 10.5)
7	-	Post fuser sensor (Q10-120) (P/O PL 10.11 Item 1)
8	-	Offset sensor (Q10-300) (P/O PL 10.11 Item 1)
9	-	Inverter motor (MOT10-030) (P/O PL 10.11 Item 1) (REP 10.3)
10	-	Not used
11	-	Locking washer (P/O PL 10.11 Item 1)
12	-	Drive roll (P/O PL 10.11 Item 1)
13	-	Not used
14	-	Offset motor (MOT10-500) (P/O PL 10.11 Item 1) (REP 10.4)
15	-	Offset motor bracket (P/O PL 10.11 Item 1)
16	-	Nip spring (P/O PL 10.11 Item 1)
17	-	Ground wire (P/O PL 10.11 Item 1)
18	-	Exit drive gear (P/O PL 10.11 Item 1) (REP 10.5)
19	-	Corrugator roll (P/O PL 10.11 Item 1) (REP 10.5)
20	-	Not used
21	806E61930	Exit roll (REP 10.5)
22	059E15983	Shuttle (REP 10.5)

23	-	Static eliminator (P/O PL 10.11 Item 1)
24	-	Inverter cover (P/O PL 10.11 Item 1)
25	-	Bail arm assembly (REF: PL 10.17 Item 2)
26	-	Sensor harness (P/O PL 1.10 Item 24)
27	-	Inverter motor harness (P/O PL 1.10 Item 24)

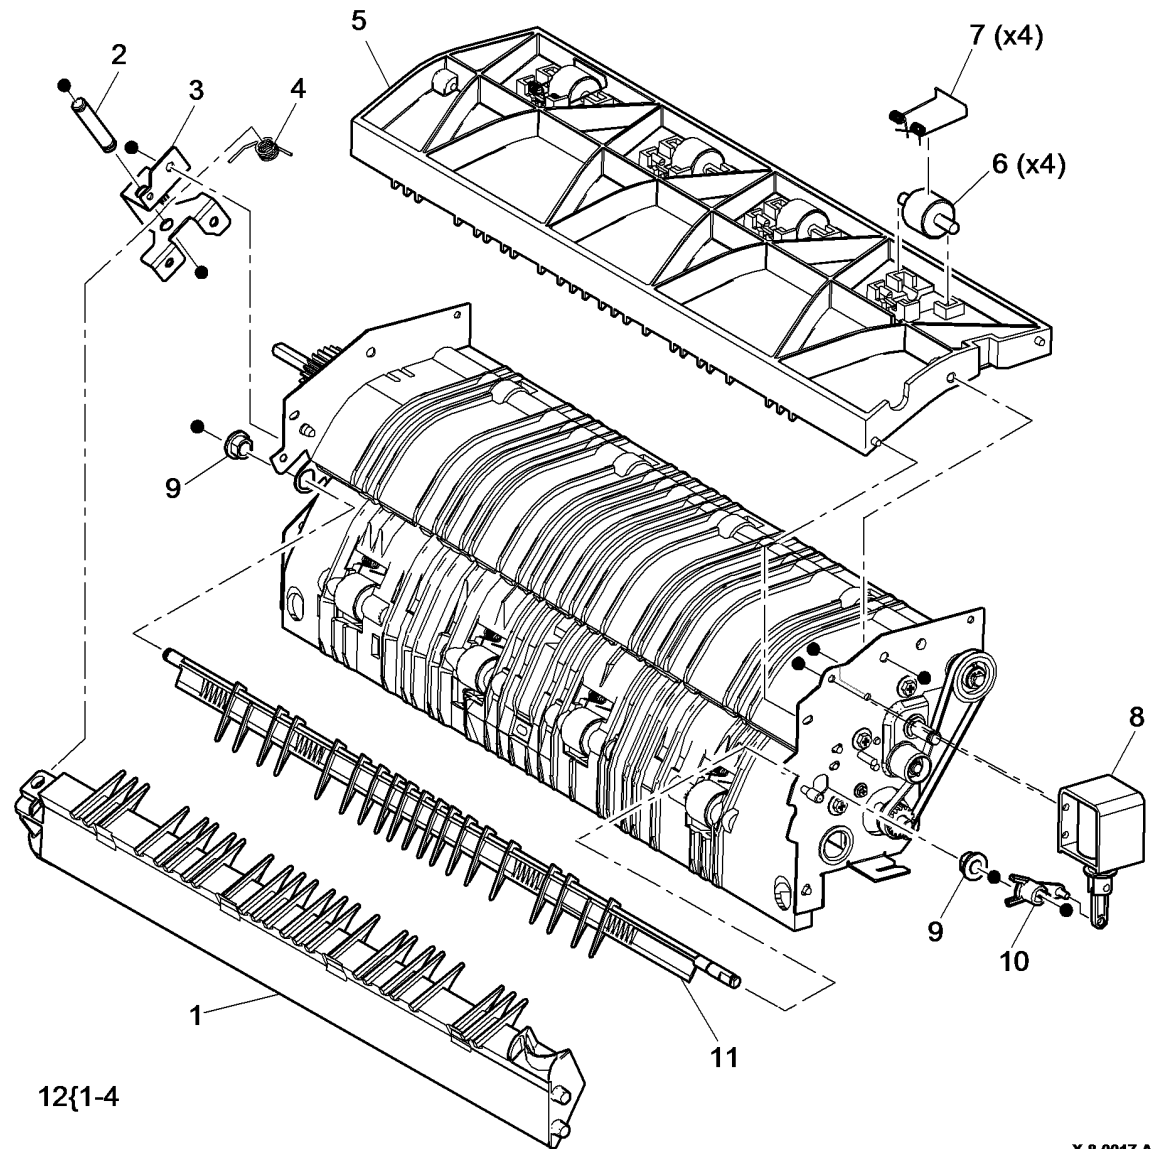
PL 10.13 Inverter Assembly (3 of 3)

Item	Part	Description
1	-	Jam clearance paper guide (P/O PL 10.13 Item 12)
2	-	Hinge pin (P/O PL 10.13 Item 12)
3	-	Hinge pin bracket (P/O PL 10.13 Item 12)
4	-	Spring (P/O PL 10.13 Item 12)
5	-	Upper exit guide (P/O PL 10.11 Item 1)
6	-	Idle roll (P/O PL 10.11 Item 1)
7	-	Spring (P/O PL 10.11 Item 1)
8	-	Inverter gate solenoid (SOL10-045) (P/O PL 10.11 Item 1)
9	-	Bearing (P/O PL 10.11 Item 1) (REP 10.5)
10	-	Pivot arm (P/O PL 10.11 Item 1)
11	-	Inverter gate (P/O PL 10.11 Item 1)
12	927K02460	Jam clearance paper guide & hinge assembly (REP 10.8)

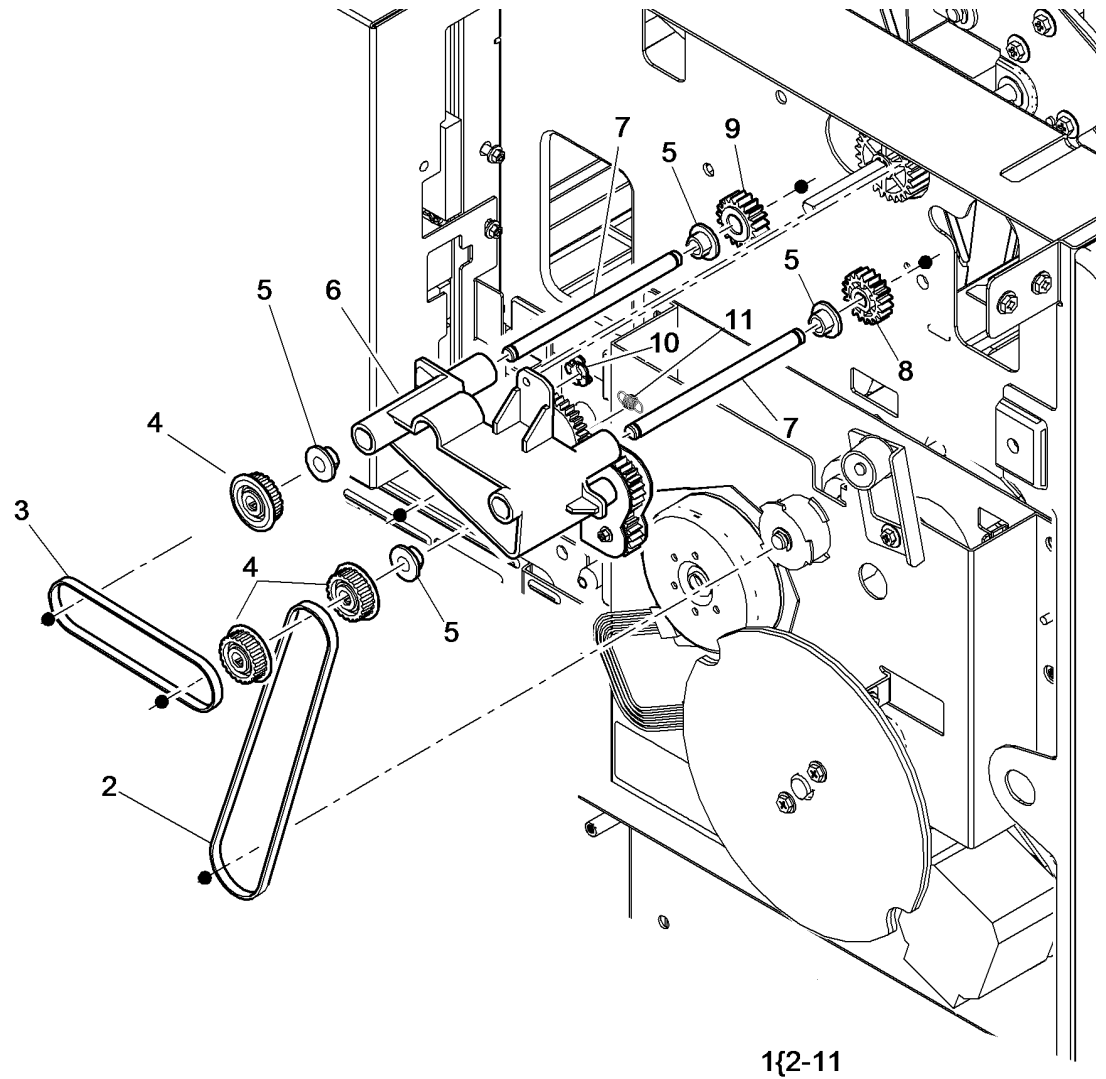
PL 10.14 Exit Drive Assembly

Item	Part	Description
1	007K20735	Exit drive assembly (REP 10.2, ADJ 40.1)
2	-	Exit drive belt (P/O PL 10.14 Item 1)
3	-	Belt (P/O PL 10.14 Item 1)
4	-	Pulley (P/O PL 10.14 Item 1)
5	-	Bearing (P/O PL 10.14 Item 1)
6	-	Exit drive housing (P/O PL 10.14 Item 1)
7	-	Drive shaft (P/O PL 10.14 Item 1)
8	-	Drive gear (P/O PL 10.14 Item 1)
9	-	Clutch gear (P/O PL 10.14 Item 1)
10	-	Offset bearing (P/O PL 10.14 Item 1)
11	-	Spring (P/O PL 10.14 Item 1)

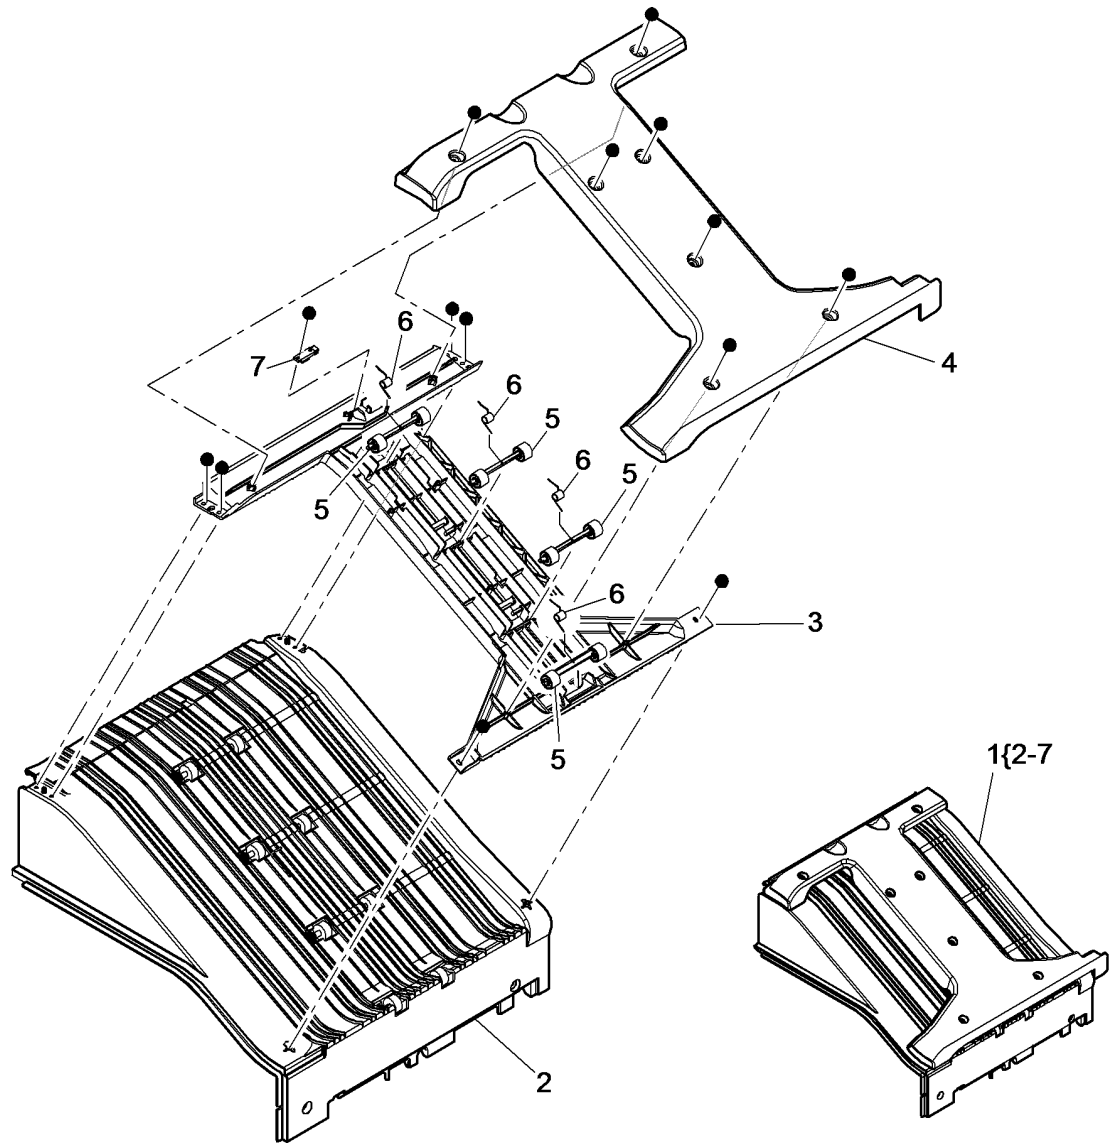
PL 10.15 Horizontal Transport Assembly (1 of 2)

Item	Part	Description
1	859K18332	Horizontal transport assembly (S NOTE) (REP 10.6)
2	–	Lower transport assembly (P/O PL 10.15 Item 1)
3	–	Upper paper guide (P/O PL 10.15 Item 1)
4	–	Exit cover (P/O PL 10.15 Item 1)
5	–	Idler roll (P/O PL 10.15 Item 1)
6	–	Spring (P/O PL 10.15 Item 1)
7	–	Horizontal transport entry sensor (Q10-041) (P/O PL 10.15 Item 1)

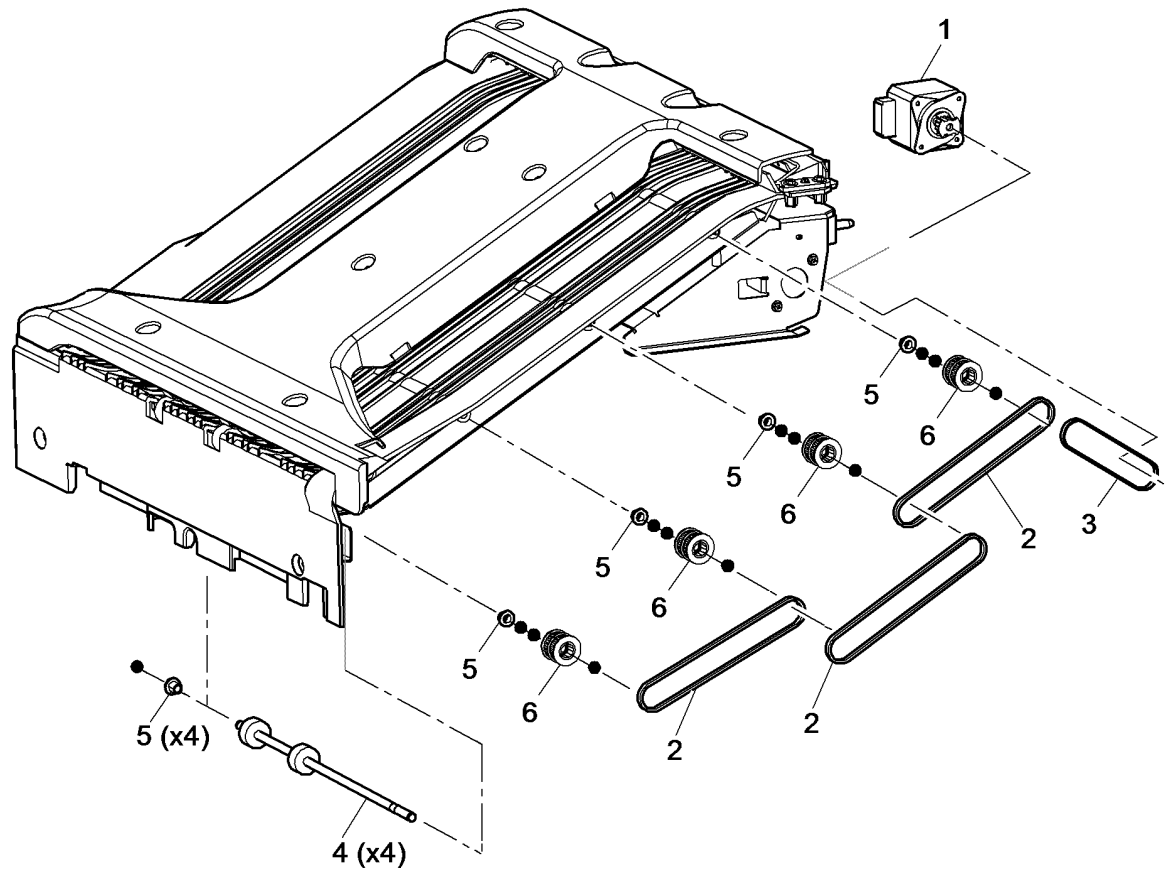
PL 10.16 Horizontal Transport Assembly (2 of 2)

Item	Part	Description
1	927K02400	Horizontal transport motor (MOT10-040) (REP 10.7)
2	023E34400	Horizontal transport drive belt
3	-	Horizontal transport motor drive belt (REP 10.7)
4	-	Horizontal transport roll (P/O PL 10.15 Item 1)
5	-	Bearing (P/O PL 10.15 Item 1)
6	-	Pulley (P/O PL 10.15 Item 1)

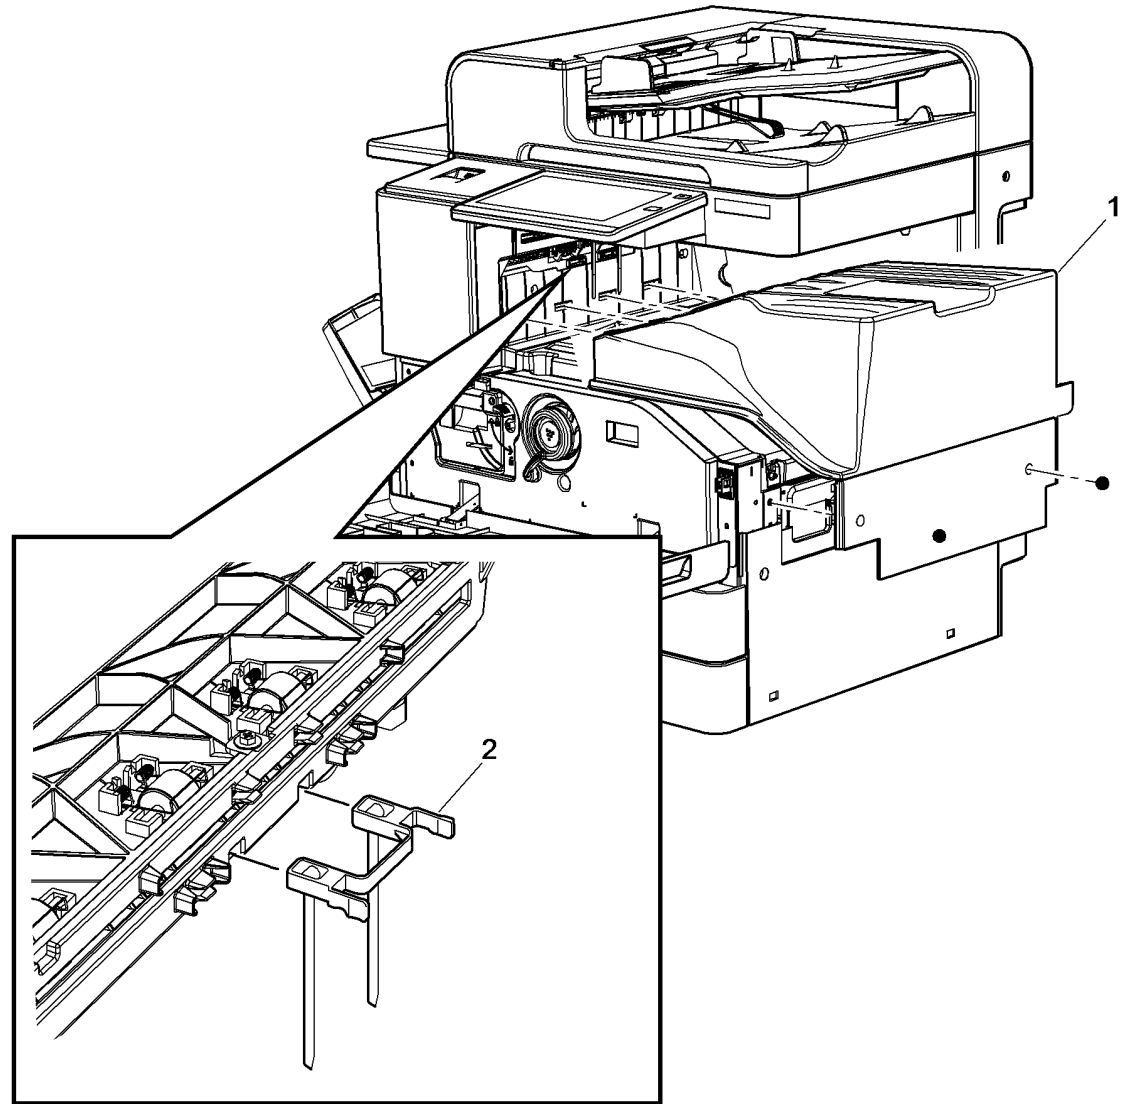
PL 10.17 Centre Output Tray Assembly

Item	Part	Description
1	-	Centre output tray assembly (P/O PL 31.14 Item 16)
2	036K01793	Bail arm assembly (See NOTE)

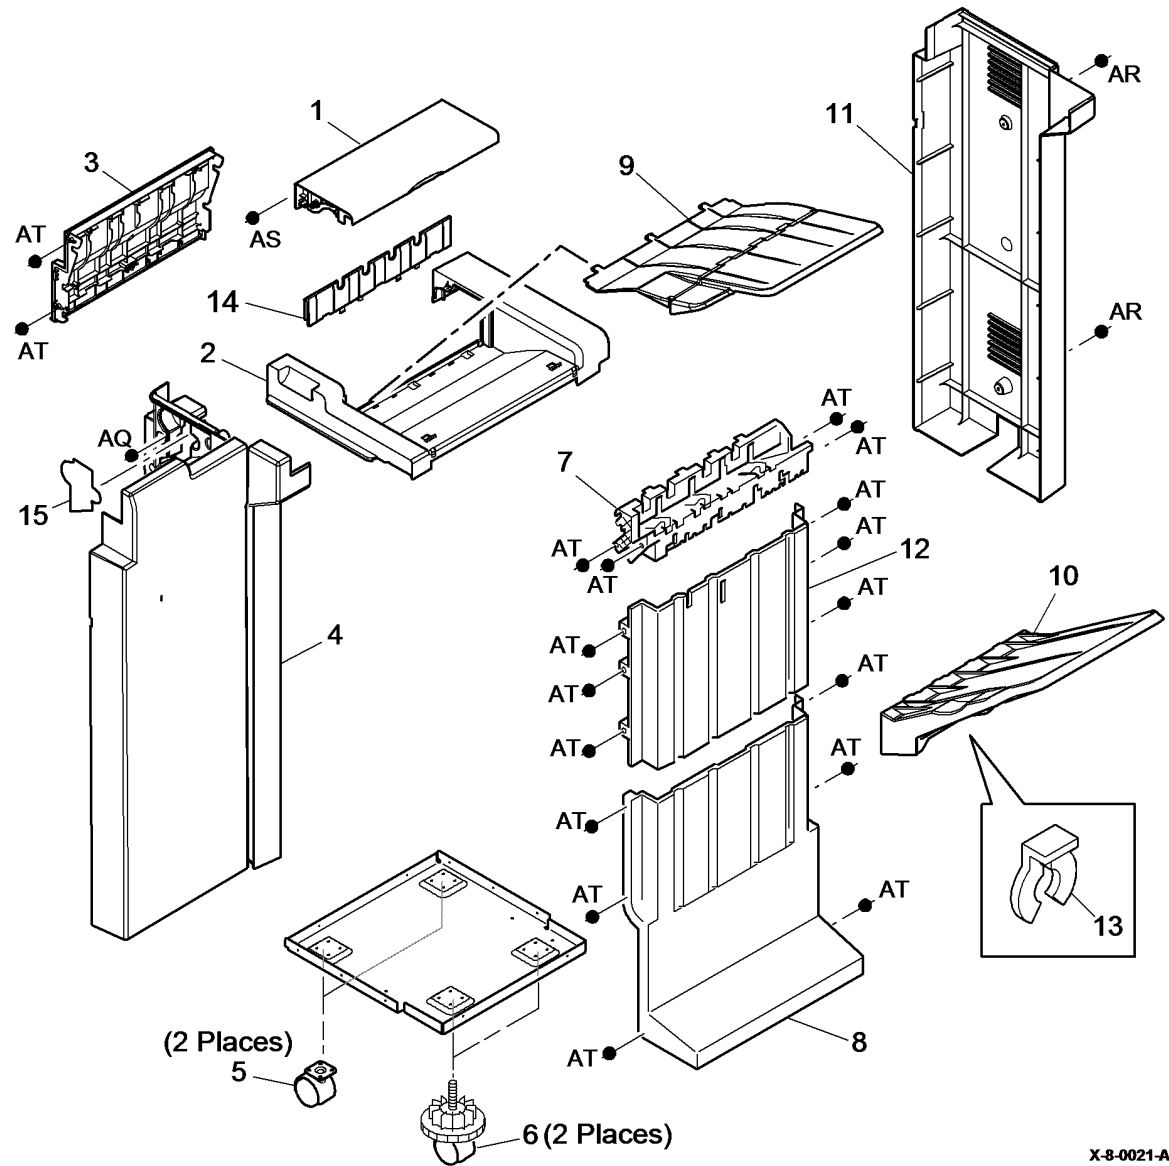
PL 12.10 2K LCSS Covers

Item	Part	Description
1	948K25970	Exit cover
2	822E52611	Top cover (REP 12.1-110)
3	848K31330	Entry guide cover (REP 12.15-110)
4	948K22201	Front door cover assembly (REP 12.1-110)
5	017K03750	Fixed caster
6	017K04520	Adjustable caster
7	-	Output cover (Not Spared)
8	802K48320	Lower right cover
9	050K75970	Bin 0
10	050K75960	Bin 1 (ADJ 12.1-110)
11	948K25871	Rear cover (REP 12.1-110)
12	-	Upper right cover (Not Spared)
13	019K13380	Bin 1 alignment clip
14	848E97200	Top centre cover
15	-	Hole punch assembly cover (Not Spared)

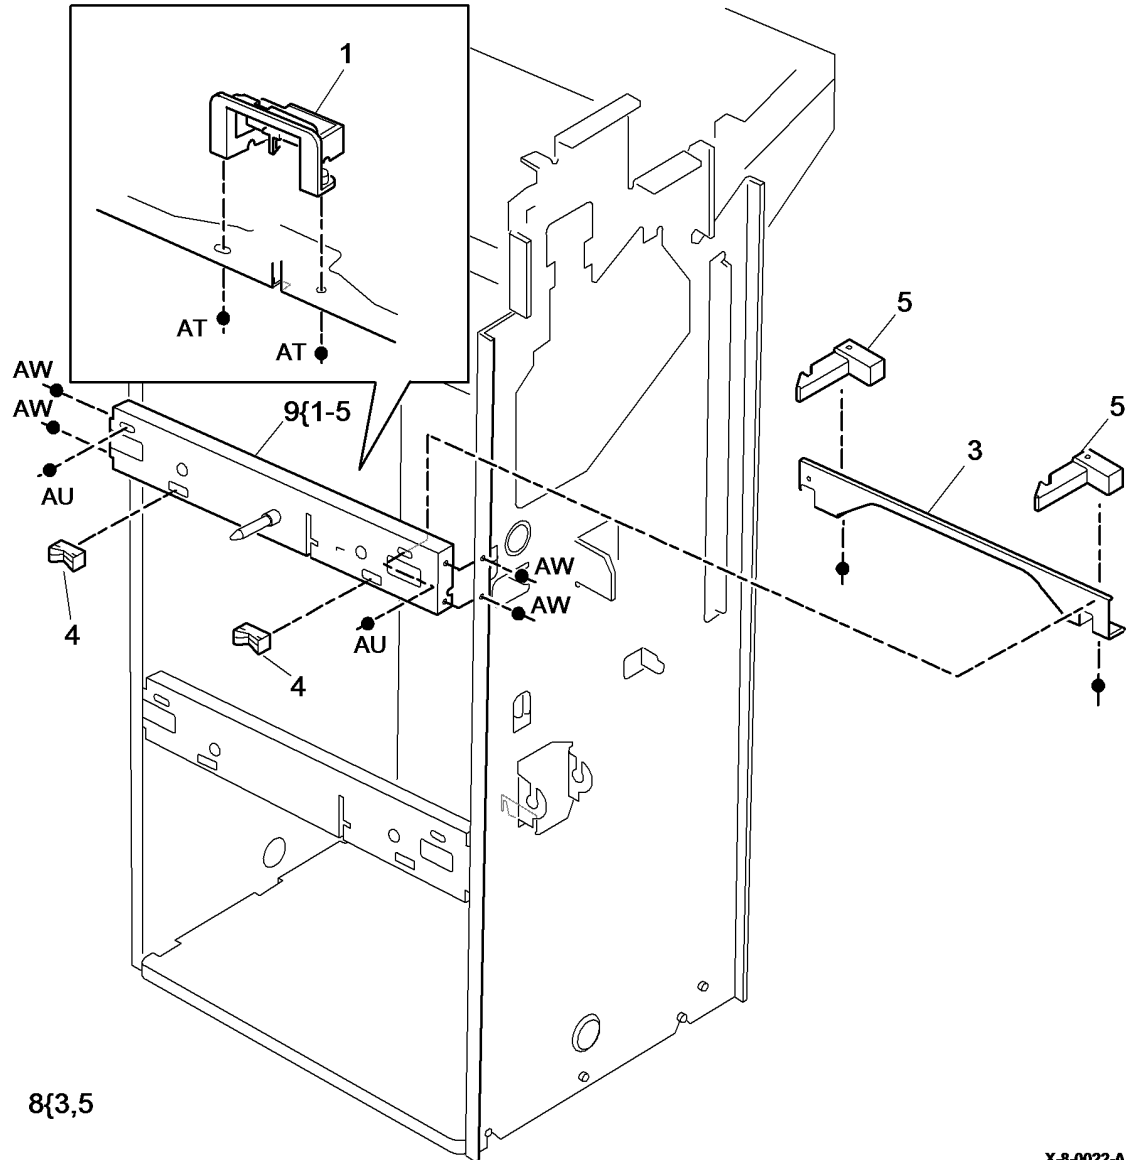
PL 12.15 2K LCSS Docking Latch

Item	Part	Description
1	-	Sensor cover (P/O PL 12.15 Item 9)
2	-	Not used
3	-	Link bracket assembly (P/O PL 12.15 Item 8)
4	-	Stopper (P/O PL 12.15 Item 9)
5	-	Docking latch (P/O PL 12.15 Item 8)
6	-	Not used
7	-	Not used
8	003K25990	Docking latch assembly (See NOTE) (REP 12.16-110)
9	003K20940	Mounting stay assembly

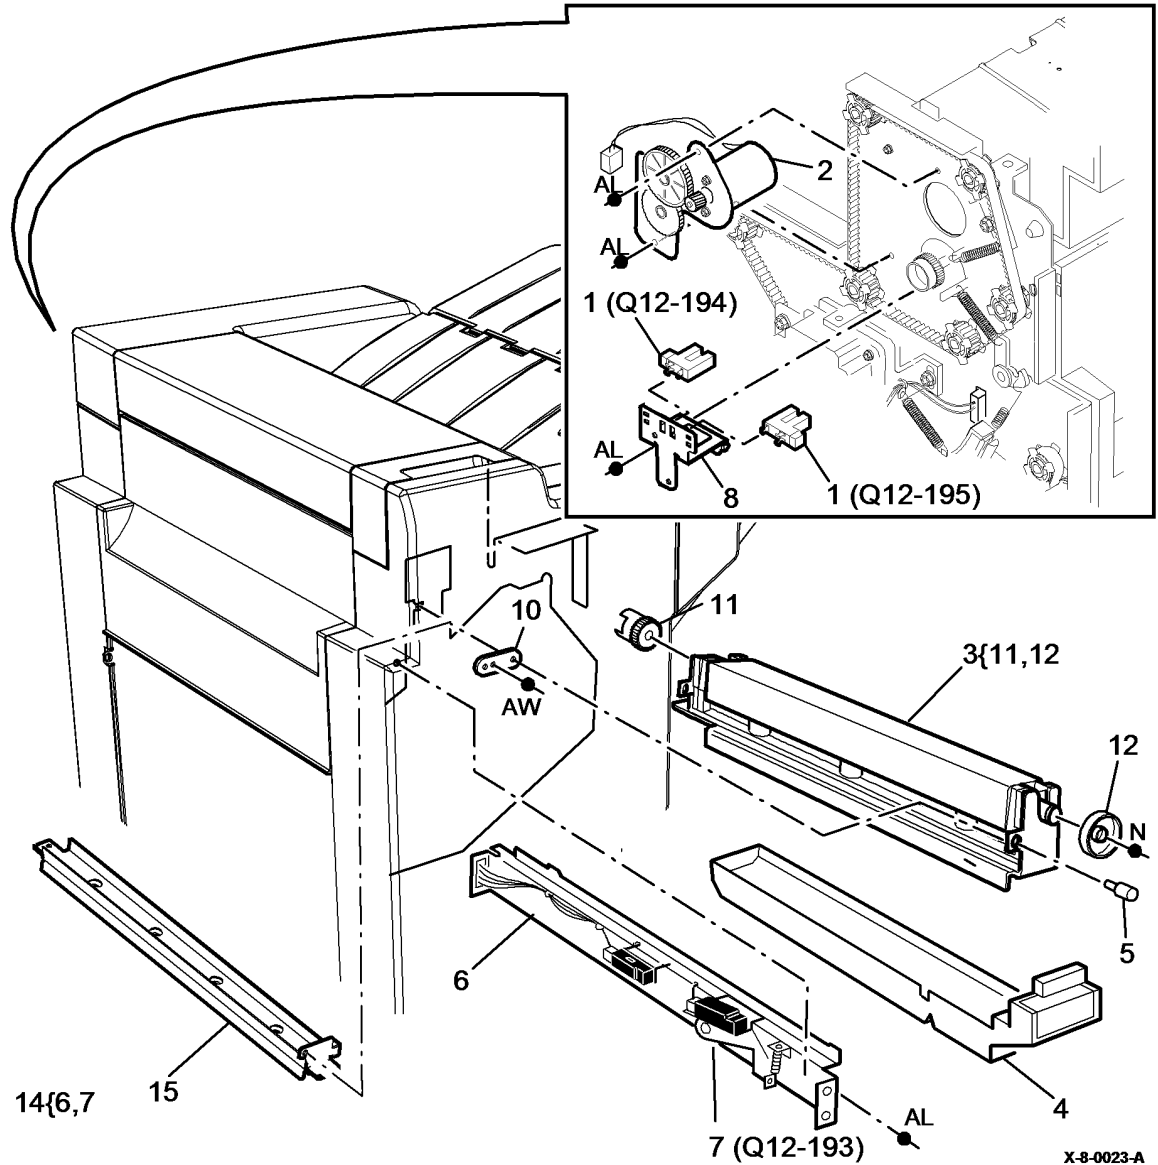
PL 12.20 2K LCSS Hole Punch Unit

Item	Part	Description
1	130E10360	Punch head home sensor (Q12-194), Punch head present sensor (Q12-195) (REP 12.7-110)
2	127K55900	Punch head motor assembly (MOT12-244) (REP 12.7-110)
3	–	Hole punch unit (see below for variants) (See NOTE) (REP 12.7-110)
–	180K01540	2 Hole (P/O PL 31.11 Item 2) (XE)
–	–	4 Hole (Sweden) (P/O PL 31.11 Item 2)
–	–	4 Hole (XE) (P/O PL 31.11 Item 2)
–	180K01570	3 Hole (unique)
–	180K01550	3 Hole (standard)
4	093E03930	Chad bin
5	–	Thumbscrew (Not Spared)
6	–	Bracket (P/O PL 12.20 Item 14)
7	130E10380	Punch sensor 1 (Q12-078), Chad bin level sensor (Q12-193) (P/O PL 12.20 Item 14) (REP 12.7-110)
8	–	Sensor bracket (Not Spared)
9	–	Not used
10	–	Bracket (Not Spared)
11	–	Punch drive gear (P/O PL 12.20 Item 3)
12	–	Punch cam (P/O PL 12.20 Item 3)
13	–	Not used
14	–	Punch sensor assembly (Not Spared)
15	014K10610	Hole punch guide assembly

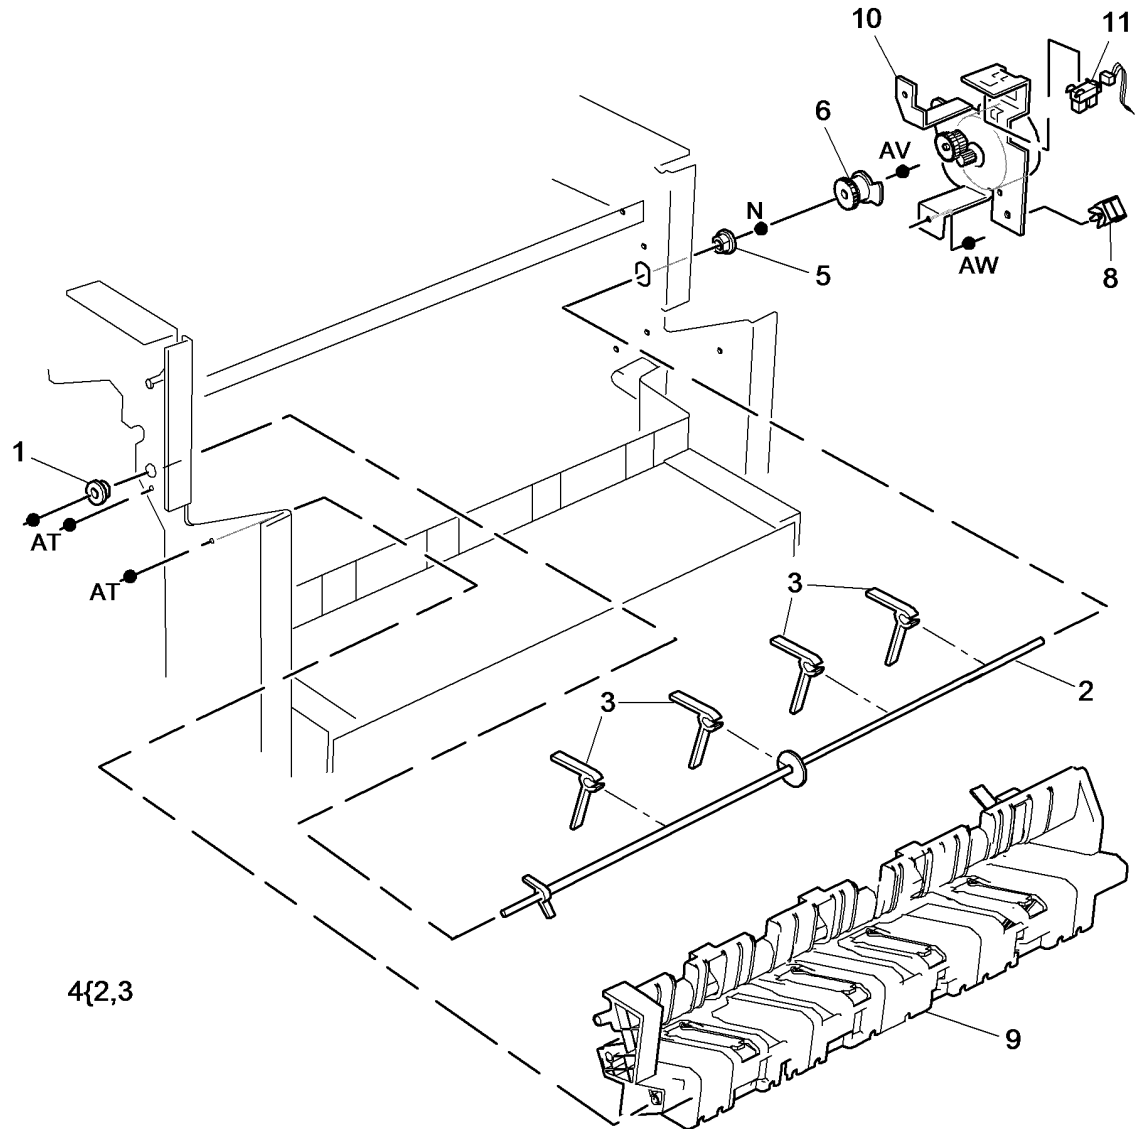
PL 12.25 2K LCSS Paddle Shaft Assembly

Item	Part	Description
1	-	Bush (Not Spared)
2	-	Shaft (P/O PL 12.25 Item 4)
3	-	Paddle (P/O PL 12.25 Item 4) (See NOTE) (REP 12.18-110)
4	-	Paddle shaft assembly (REF: PL 31.12 Item 2) (REP 12.12-110)
5	013E25790	Nylon bearing
6	-	Gear and flag assembly (Not Spared)
7	-	Not used
8	-	Cable clamp (Not Spared)
9	-	Output cover (Not Spared)
10	127K62580	Paddle roll motor assembly (MOT12-238) (REP 12.12-110)
11	130E10360	Paddle roll home sensor (Q12-186)

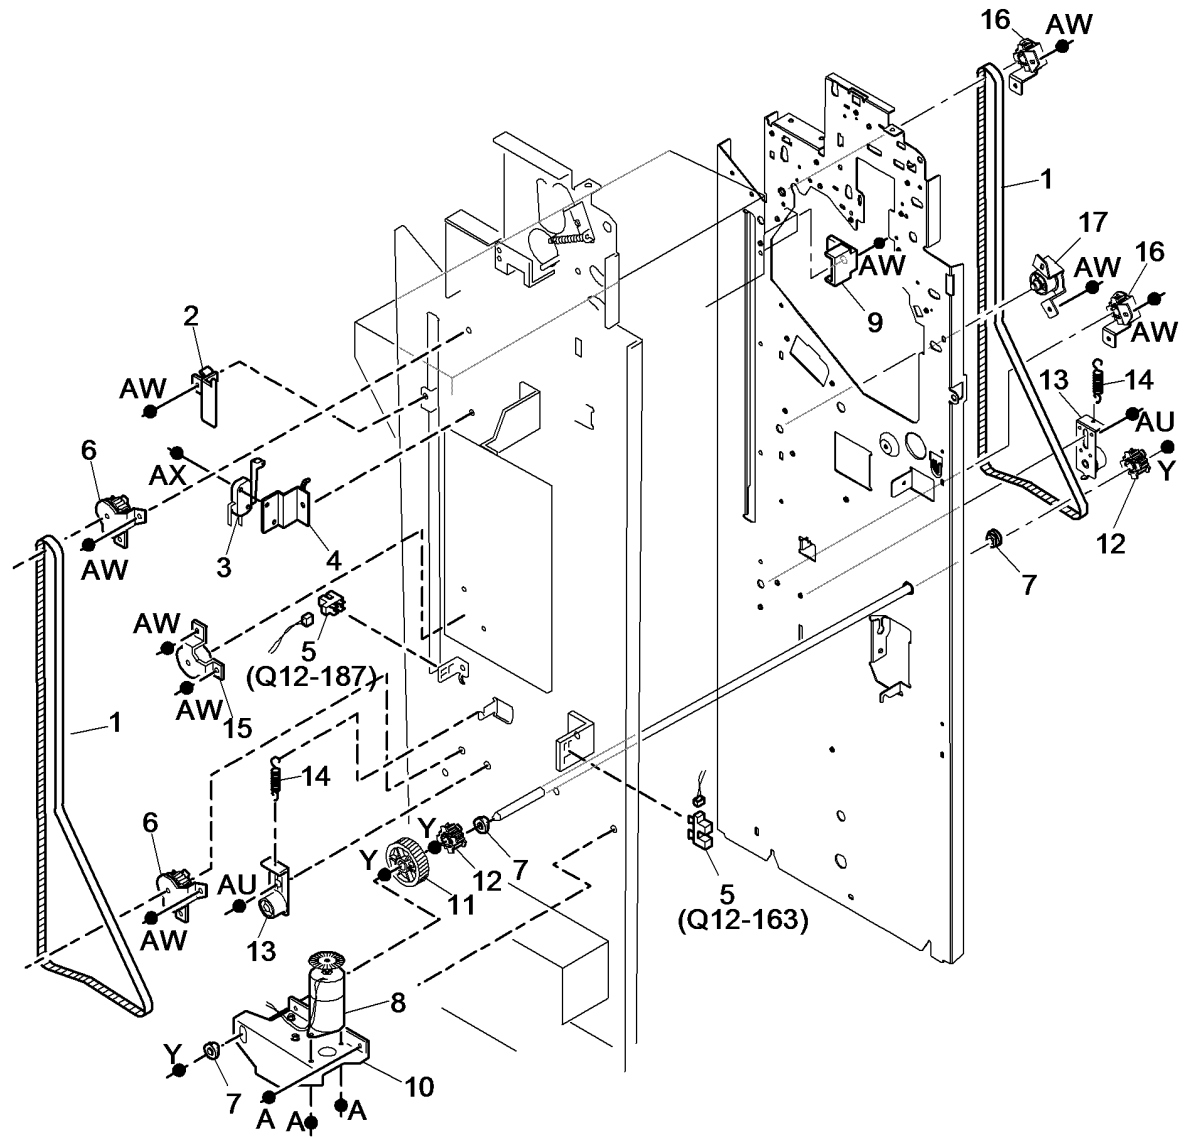
PL 12.30 2K LCSS Bin 1 Control Components (1 of 2)

Item	Part	Description
1	023E24320	Bin 1 drive belt (REP 12.5-110)
2	-	Rear belt clamp (Not Spared) (ADJ 12.1-110)
3	110E20180	Bin 1 upper limit switch (S12-190)
4	-	Sensor bracket (Not Spared)
5	130E10360	Bin 1 90% full sensor (Q12-187)/ Bin 1 motor encoder sensor (Q12-163)
6	-	Rear pulley (Not Spared) (ADJ 40.1)
7	013E37470	Bearing
8	127K55891	Bin 1 elevator motor (MOT12-241)
9	-	Front belt clamp (Not Spared) (ADJ 12.1-110)
10	-	Motor bracket (Not Spared)
11	-	Drive gear (Not Spared)
12	-	Drive pulley assembly (Not Spared)
13	-	Belt tensioner (Not Spared) (ADJ 40.1)
14	-	Spring (Not Spared)
15	-	Rear idler (Not Spared) (ADJ 40.1)
16	-	Front pulley (Not Spared) (ADJ 40.1)
17	-	Front idler (Not Spared) (ADJ 40.1)
