708P91368
September 2017

Xerox® AltaLink® B8090 Family Multifunction Printer Service Manual

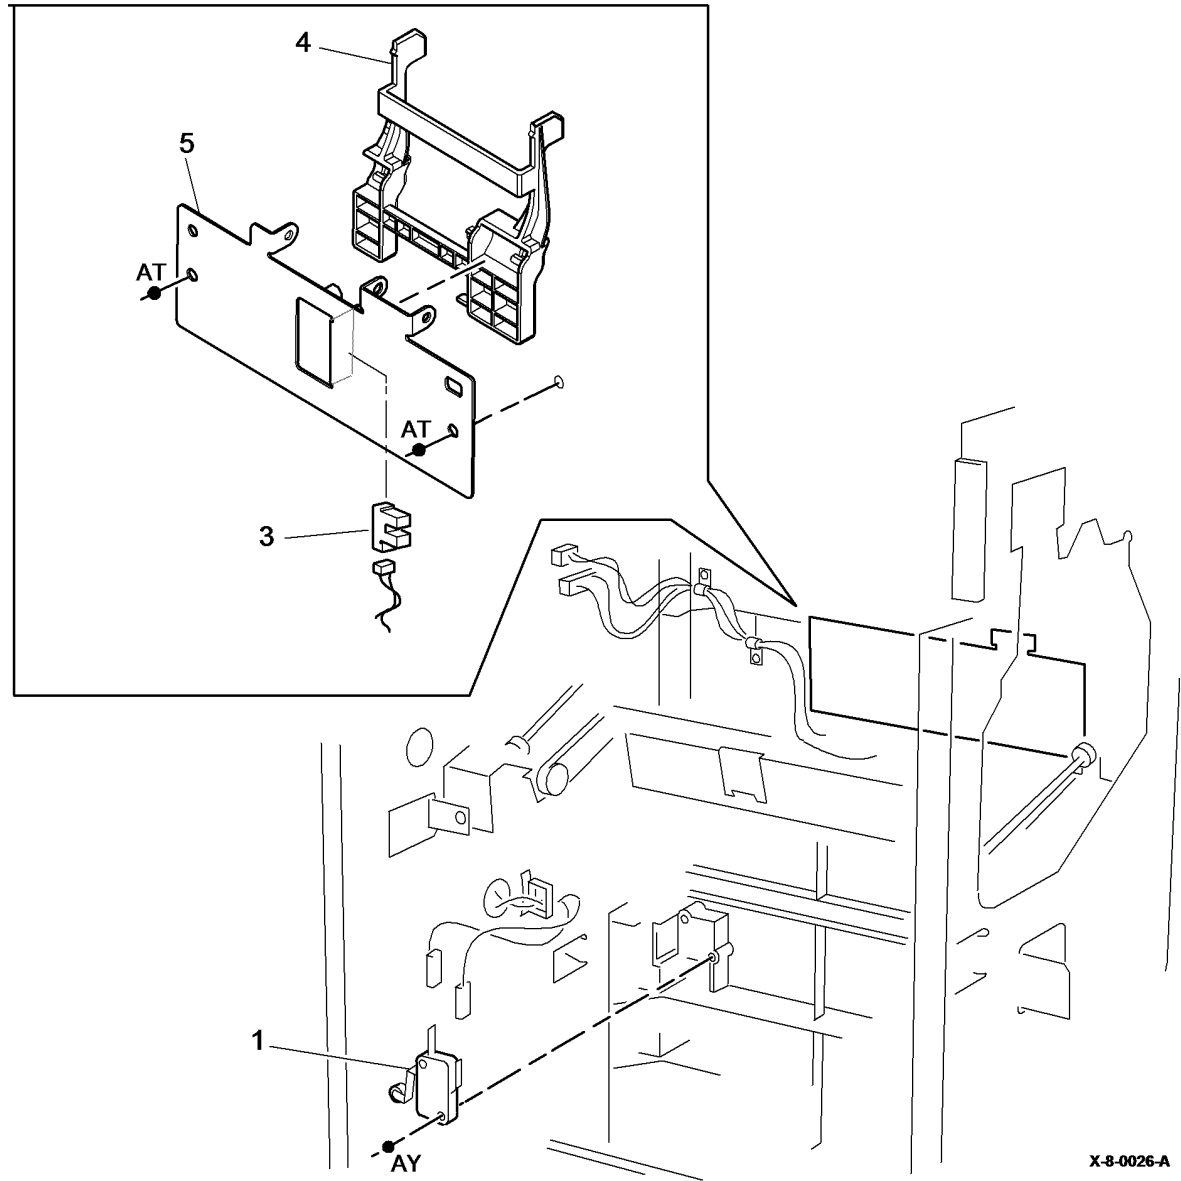
PL 12.35 2K LCSS Bin 1 Control Components (2 of 2)

Item	Part	Description
1	110K13990	Bin 1 lower limit switch (S12-191)
2	-	Not used
3	130E10360	Bin 1 upper level sensor (Q12-188) (REP 12.11-110)
4	-	Actuator (Not Spared)
5	-	Sensor support assembly (Not Spared)

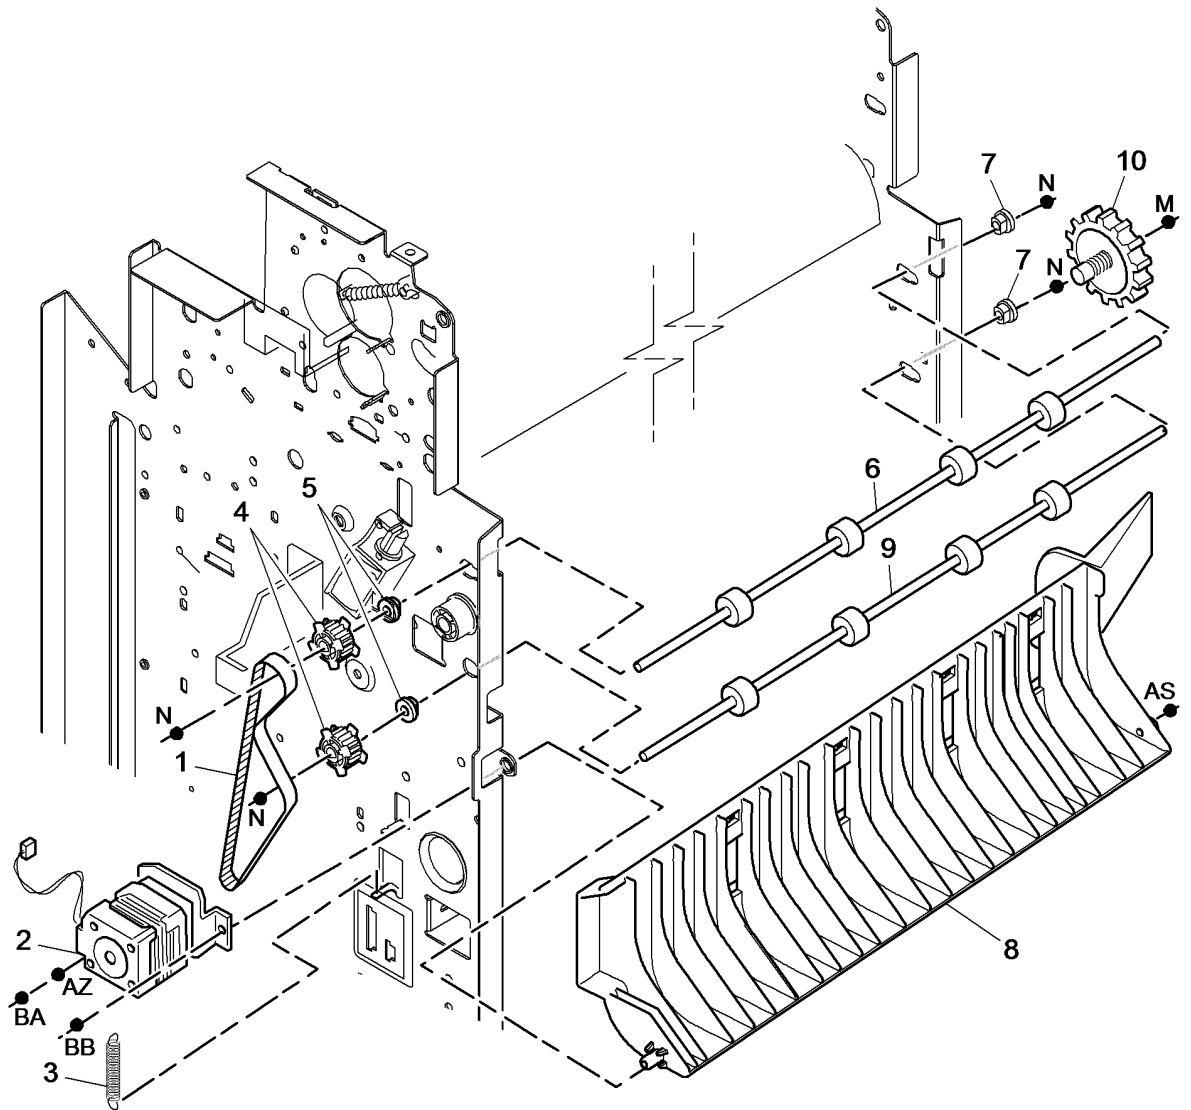
PL 12.40 2K LCSS Paper Entry Transport

Item	Part	Description
1	023E24340	Input drive belt (REP 12.2-110)
2	127K55860	Transport motor 1 (MOT12-223) (REP 12.2-110, ADJ 12.3-110)
3	-	Spring (Not Spared)
4	-	Pulley (Not Spared)
5	013E37460	Bearing
6	-	Feed roll shaft (short) (Not Spared)
7	013E37470	Bearing
8	-	Jam clearance guide assembly (REF: PL 12.70 Item 1)
9	-	Feed roll shaft (long) (Not Spared)
10	006K32780	Thumb wheel

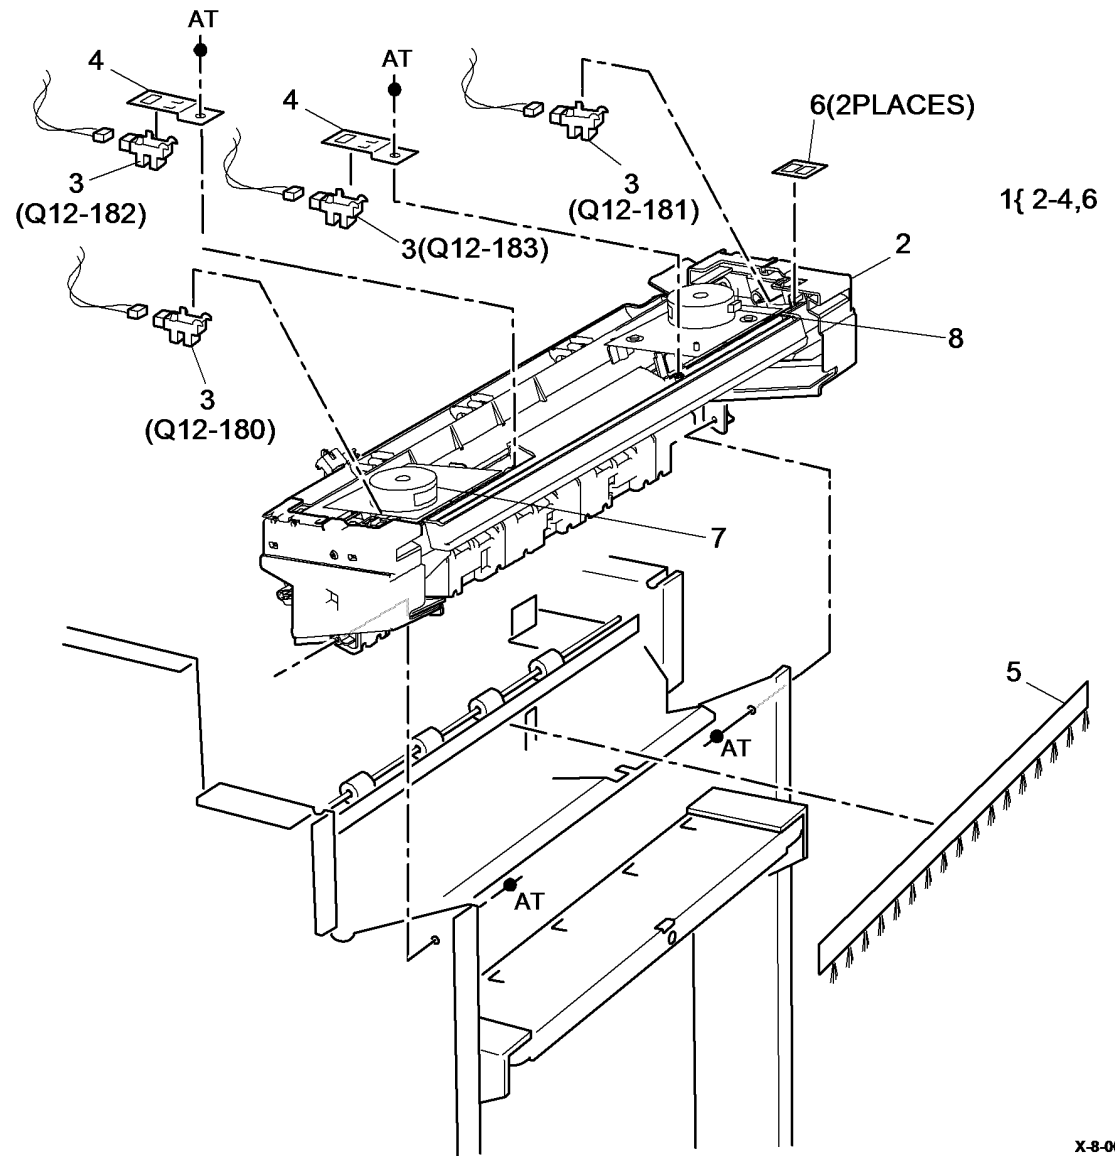
PL 12.45 2K LCSS Tamper Assembly

Item	Part	Description
1	049K50680	Tamper assembly (REP 12.6-110)
2	-	Tamper unit (P/O PL 12.45 Item 1)
3	130E10360	Front tamper home sensor (Q12-180), Front tamper away sensor (Q12-182), Rear tamper home sensor (Q12-181), Rear tamper away sensor (Q12-183)
4	-	Sensor bracket (P/O PL 12.45 Item 1)
5	-	Static eliminator (stacker) (REF: PL 12.65 Item 7)
6	-	Sensor retainer (P/O PL 12.45 Item 1)
7	-	Front tamper motor (MOT12-226) (P/O PL 12.45 Item 1)
8	-	Rear tamper motor (MOT12-227) (P/O PL 12.45 Item 1)
9	869E55190	Tamper arm (Not shown)

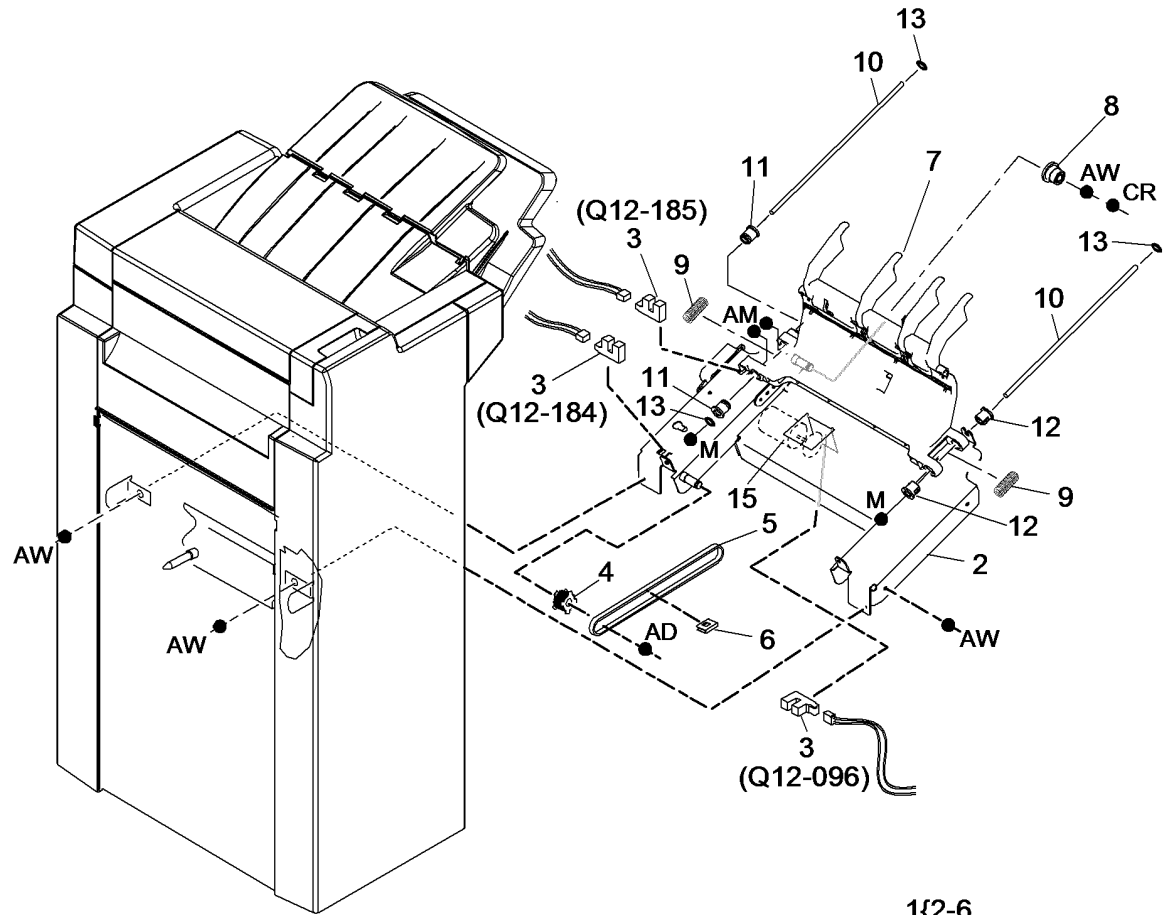
PL 12.50 2K LCSS Ejector Assembly

Item	Part	Description
1	054K43583	Ejector assembly (REP 12.10-110)
2	-	Ejector base (P/O PL 12.50 Item 1)
3	130E10360	Ejector home sensor (Q12-184), Ejector out sensor (Q12-185), Ejector motor encoder sensor (Q12-096) (REP 12.10-110)
4	-	Pulley (P/O PL 12.50 Item 1)
5	023E24330	Ejector belt (REP 12.17-110)
6	-	Clip (P/O PL 12.50 Item 1)
7	019K13390	Support finger set (Qty. 4)
8	020K21490	Pulley/drive gear
9	-	Spring (P/O PL 12.50 Item 1)
10	-	Shaft (P/O PL 12.50 Item 1)
11	-	Slide ejector bearing (P/O PL 12.50 Item 14)
12	-	Wide slide ejector bearing (P/O PL 12.50 Item 14)
13	-	Cushion washer (P/O PL 12.50 Item 14)
14	604K67690	LCSS bearing assembly kit
15	-	Ejector motor (MOT12-234) (P/O PL 12.50 Item 1)

1. Remove the 2K LCSS ejector assembly, [REP 12.10-110](#), or LVF BM ejector assembly [REP 12.10-150](#).
2. Check the ejector shafts are adequately lubricated and the slide bearings move freely along the ejector shafts:
 - 2K LCSS [PL 12.50 Item 10](#), [PL 12.50 Item 11](#) and [PL 12.50 Item 12](#).
 - LVF BM [PL 12.360 Item 11](#), [PL 12.360 Item 12](#), [PL 12.360 Item 13](#).
3. If the slide bearings are worn replace the ejector assembly:
 - 2K LCSS [PL 12.50 Item 1](#).
 - LVF BM [PL 12.360 Item 1](#).

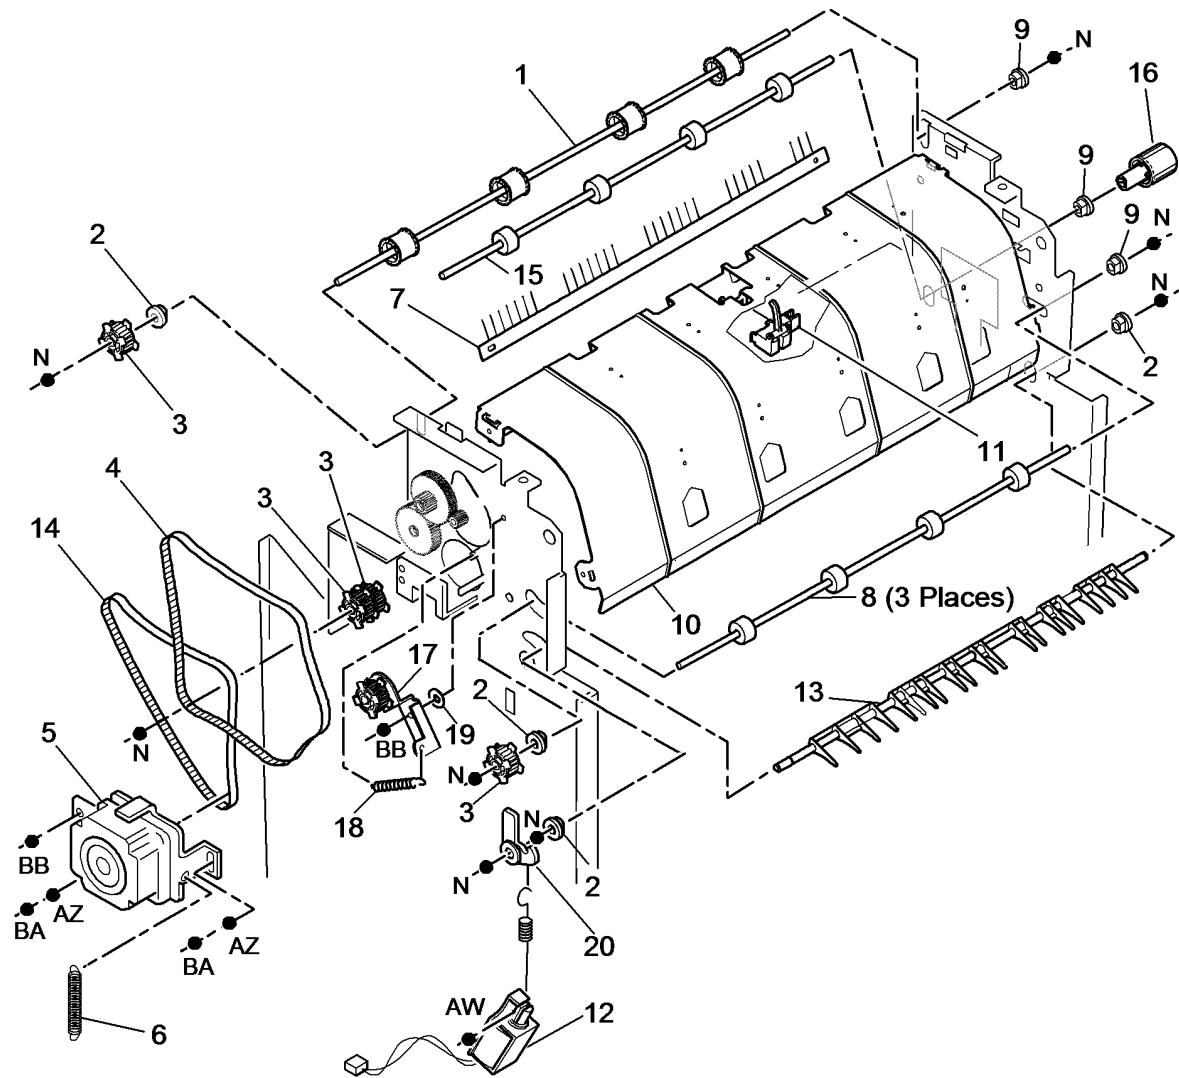
PL 12.60 2K LCSS Bin 0 Entry

Item	Part	Description
1	006K32810	Top tray exit shaft
2	013E25790	Nylon bearing
3	-	Pulley (Not Spared)
4	023E24330	Intermediate paper drive belt (REP 12.3-110)
5	127K55870	Transport motor 2 (MOT12-224) (REP 12.4-110)
6	-	Spring (Not Spared)
7	115E13440	Static eliminator
8	006K32841	Feed roll shaft (short)
9	013E37460	Bearing
10	117K54510	Paper guide (REP 12.20-110)
11	130E11440	Top tray exit sensor (Q12-107) (REP 12.20-110)
12	121K45010	Exit diverter solenoid (SOL12-225)
13	-	Exit diverter gate (P/O PL 31.12 Item 14)
14	023E24340	Paper output drive belt (REP 12.4-110)
15	006K32800	Drive shaft assembly
16	006K33961	Jam clearance knob
17	-	Belt tensioner (Not Spared)
18	-	Spring (Not Spared)
19	-	Washer (Not Spared)
20	-	Actuator (Not Spared)

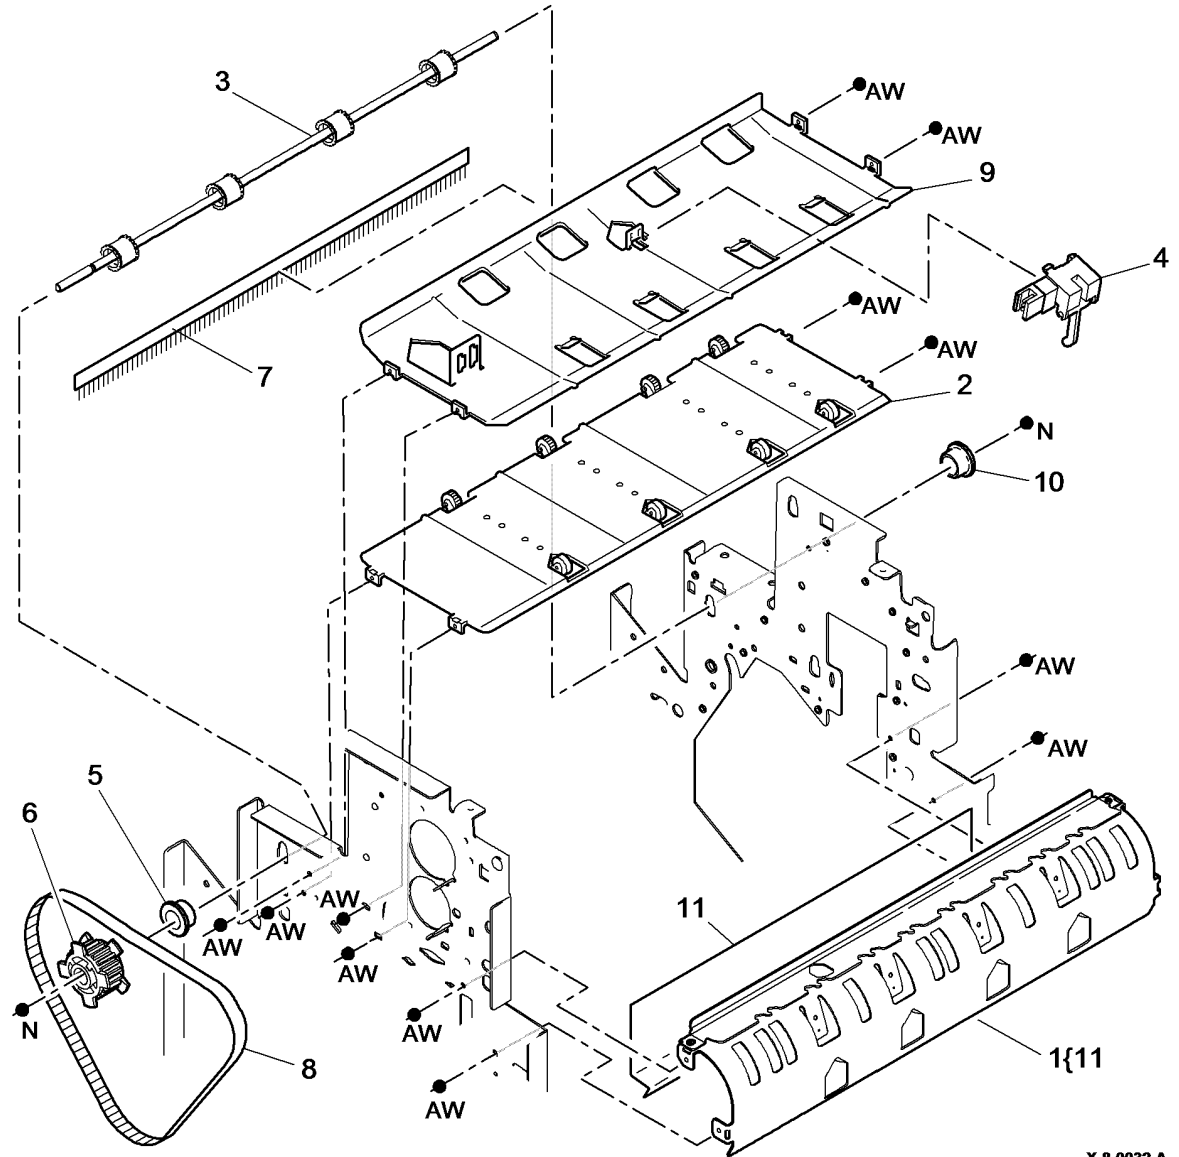
PL 12.65 2K LCSS Bin 1 Entry

Item	Part	Description
1	032K04610	Left paper guide
2	-	Lower right paper guide (Not Spared) (REP 12.19-110)
3	006K32790	Ejector drive shaft (REP 12.19-110)
4	130E11440	Compiler exit sensor (Q12-106)
5	013E25790	Nylon bearing
6	-	Pulley (Not Spared)
7	115E11810	Static eliminator (stacker)
8	-	Paper output drive belt (REF: PL 12.60 Item 14)
9	-	Upper right paper guide (Not Spared) (REP 12.19-110)
10	013E37460	Bearing
11	-	Mylar safety cover (P/O PL 12.65 Item 1)

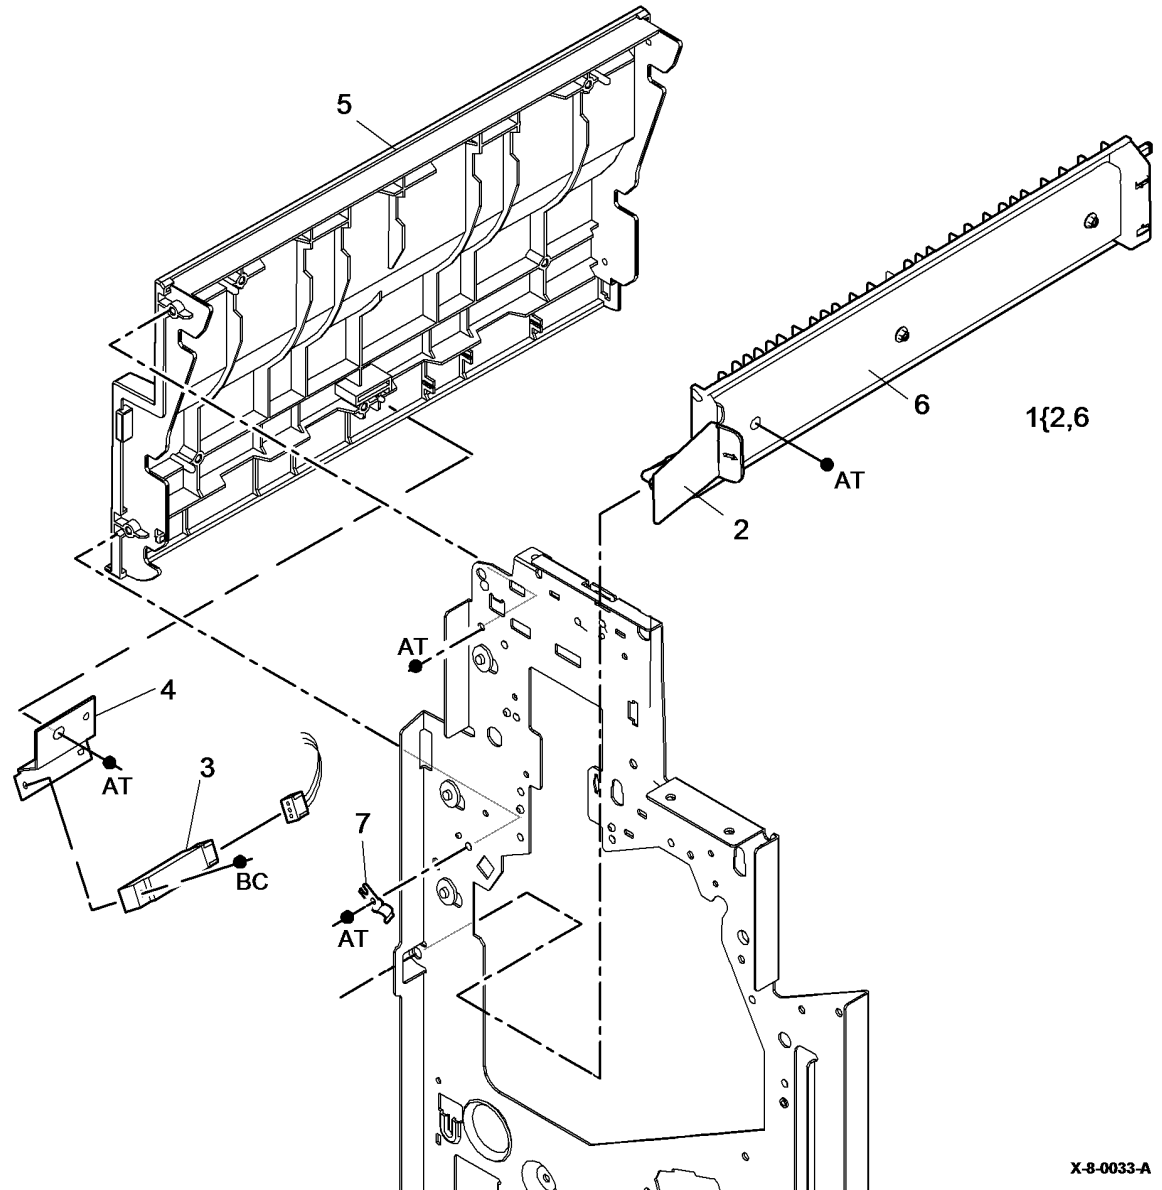
PL 12.70 2K LCSS Entry Guide Cover/ Jam Clearance Guide

Item	Part	Description
1	032K09672	Jam clearance guide assembly
2	-	Jam clearance handle (P/O PL 12.70 Item 1)
3	130E10380	Entry sensor (Q12-077)
4	-	Sensor bracket (Not Spared)
5	-	Entry guide cover (REF: PL 12.10 Item 3) (REP 12.15-110)
6	-	Jam clearance guide (P/O PL 12.70 Item 1)
7	809E78390	Latch

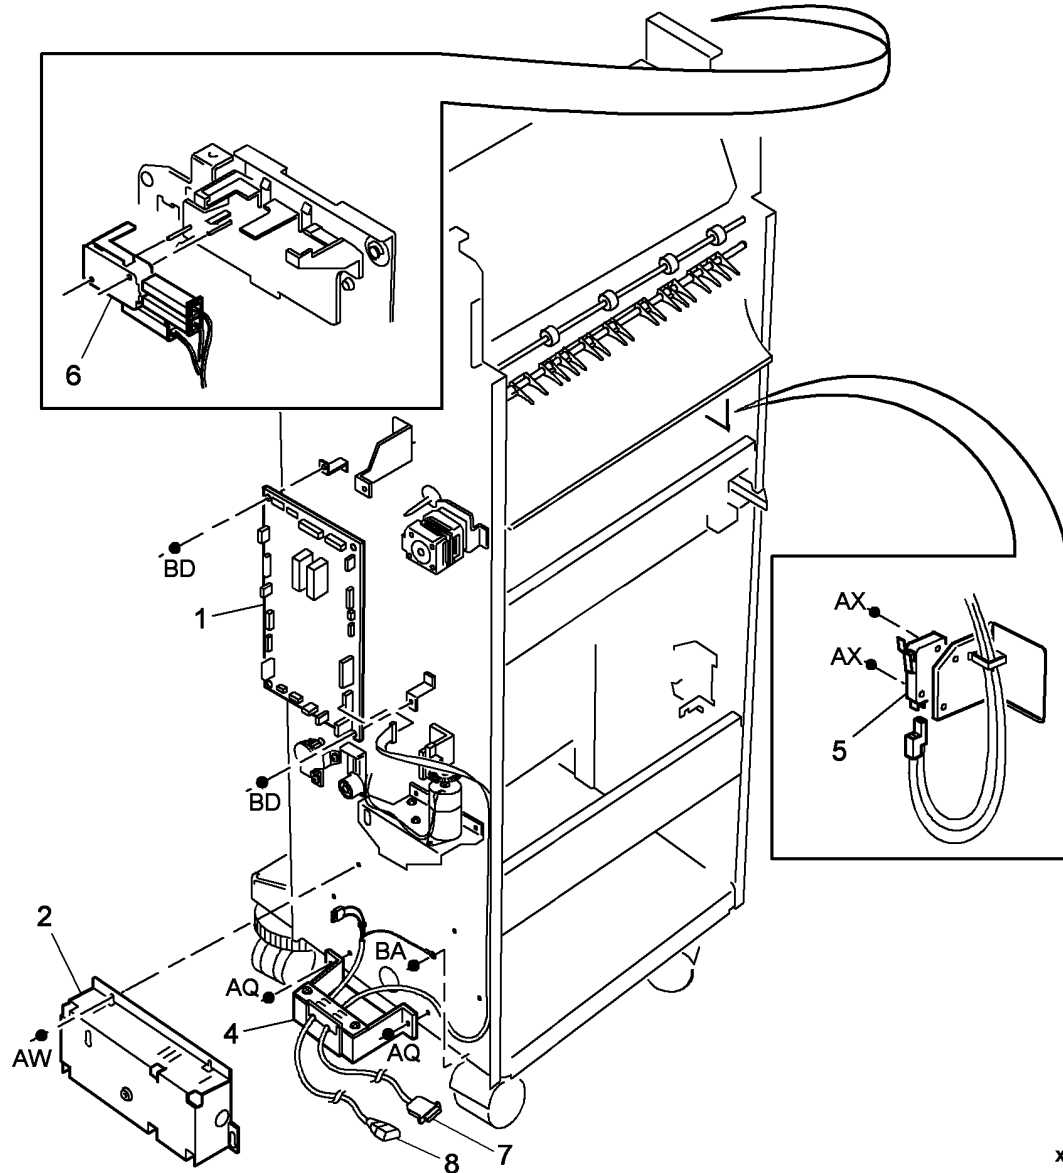
PL 12.75 2K LCSS Electrical

Item	Part	Description
1	960K97481	LCSS PWB (REP 12.14-110)
2	-	Power supply module (Not Spared)
3	-	Not used
4	962K56952	Cord bracket assembly
5	110K13980	Front door interlock switch (S12-303)
6	110K13970	Top cover interlock switch (S12-197)
7	-	LCSS communications harness (P/O PL 12.75 Item 4)
8	-	LCSS power cord (P/O PL 12.75 Item 4)

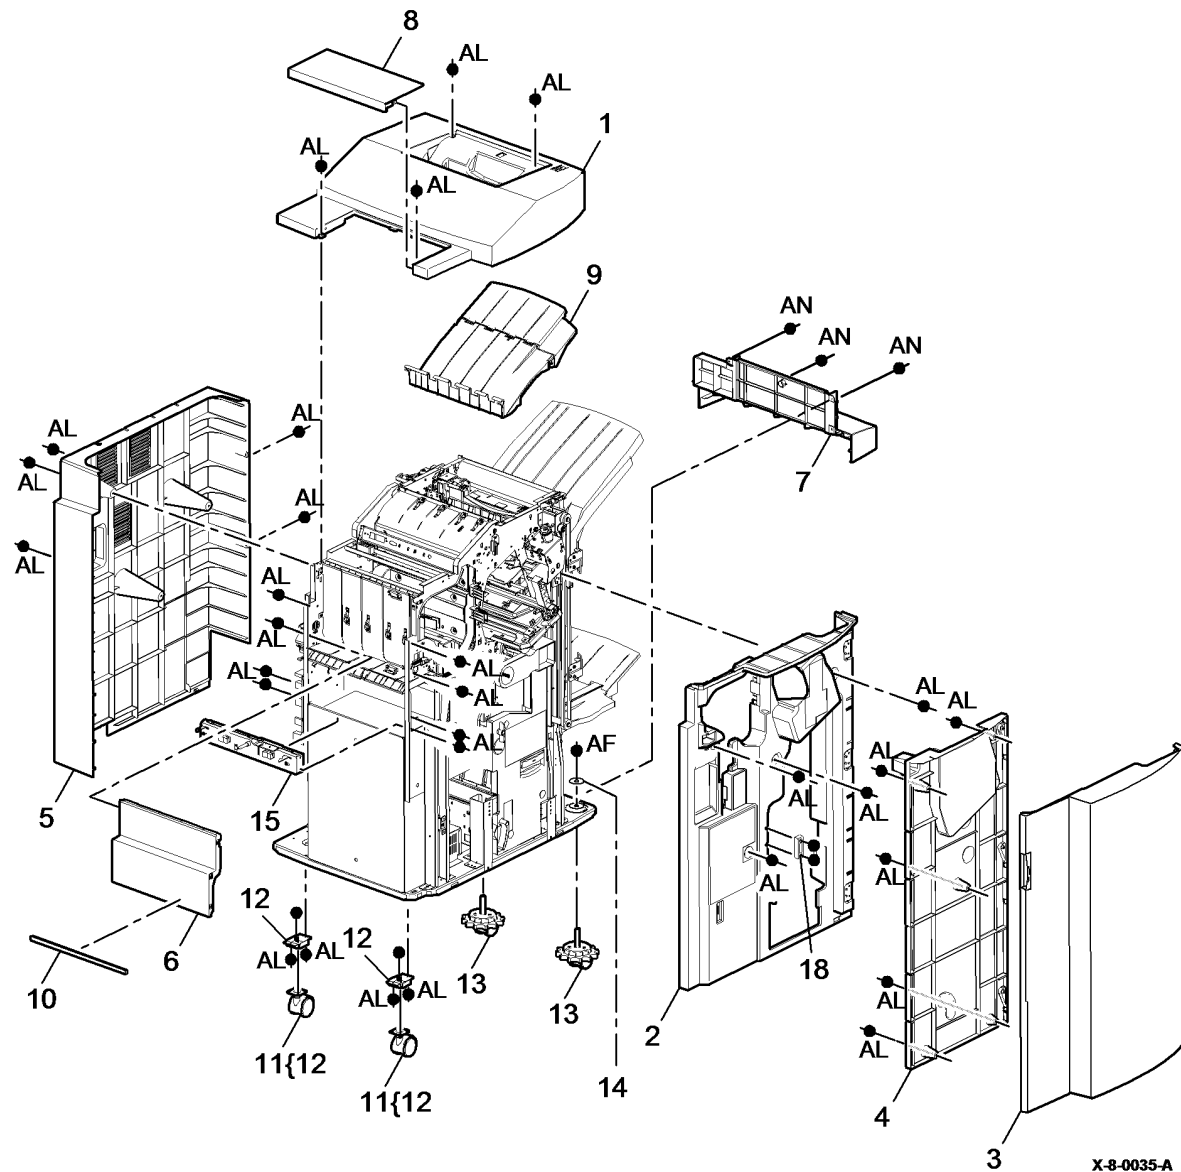
PL 12.100 HVF Covers and Docking

Item	Part	Description
1	948K23401	Top cover (REP 12.1-171)
2	948K25850	Front cover (REP 12.1-171)
3	848E17790	Front door (REP 12.1-171)
4	948K25860	Door support cover (REP 12.1-171)
5	822E58361	Rear cover (REP 12.1-171)
6	848K12530	Vent cover (REP 12.1-171)
7	848E17800	Foot cover (REP 12.1-171)
8	848E17810	Inserter cover (REP 12.1-171)
9	848E40500	Top tray (REP 12.3-171)
10	-	Seal (Not Spared)
11	017K04830	Fixed caster assembly (REP 12.96-171)
12	-	Fixed caster bracket (P/O PL 12.100 Item 11)
13	017K04630	Adjustable caster (REP 12.96-171)
14	-	Adjustable caster washer (P/O PL 12.100 Item 13)
15	017K06300	Docking latch assembly (REP 12.100-171)
16	-	Not used
17	-	Not used
18	049K13570	Bookletmaker interlock bracket

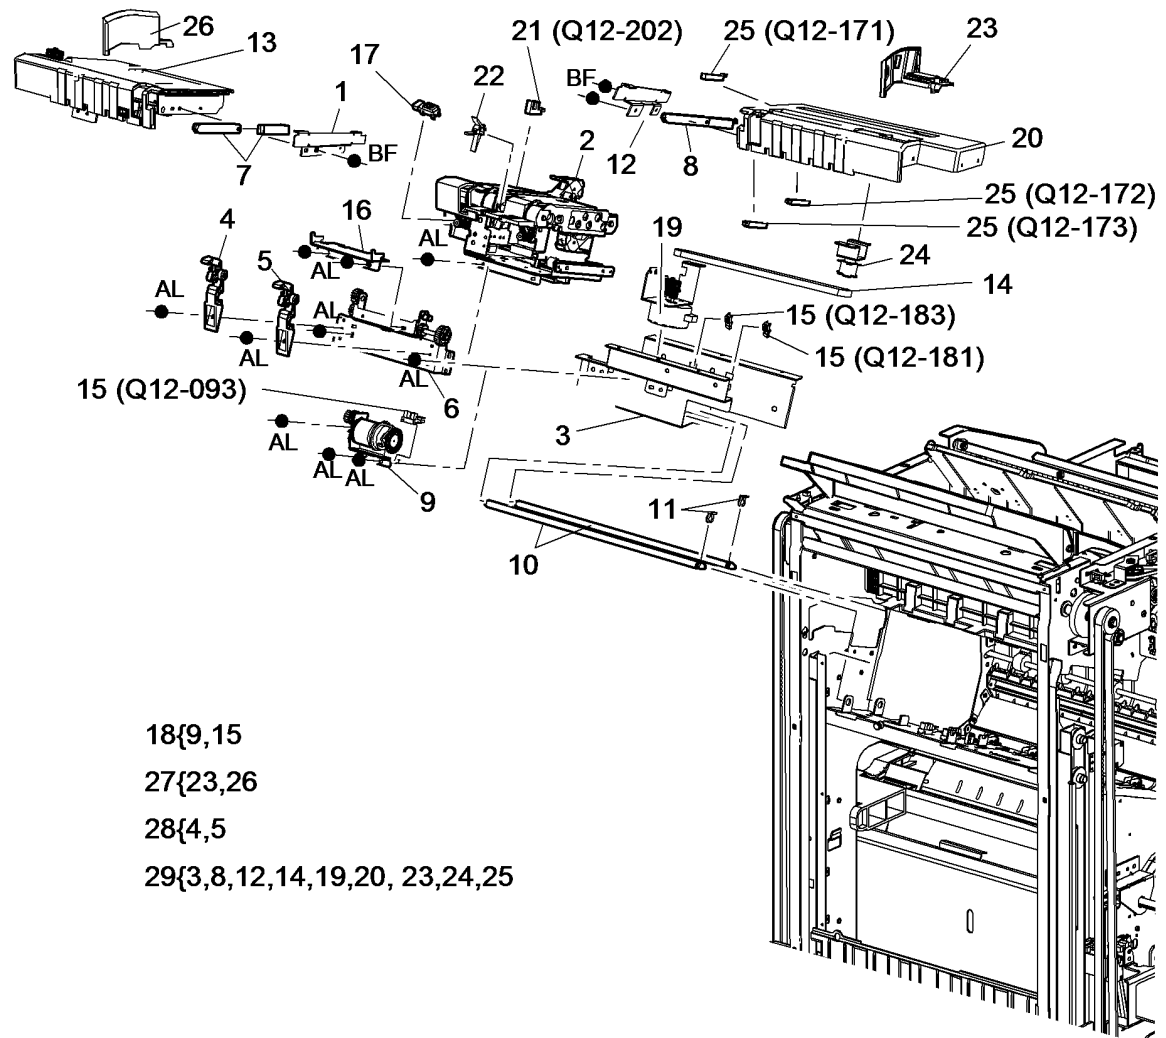
PL 12.110 HVF Ejector, Pressing and Support (1 of 3)

Item	Part	Description
1	-	Front tamper bracket (Not Spared)
2	-	Ejector assembly (P/O PL 31.12 Item 23) (REP 12.6-171)
3	-	Rear tamper support bracket (P/O PL 12.110 Item 29)
4	-	Front pressing plate finger (P/O PL 12.110 Item 28) (REP 12.7-171)
5	-	Rear pressing plate finger (P/O PL 12.110 Item 28) (REP 12.7-171)
6	049K23160	Pressing plate bracket
7	-	Front support finger (NOTE) (REP 12.8-171)
8	-	Rear support finger (NOTE) (REP 12.8-171)
9	-	Pressing and support motor (MOT12-323) (P/O PL 12.110 Item 18)
10	-	Offset rod (Not Spared)
11	019K13380	Offset rod KL clip
12	-	Rear tamper bracket (P/O PL 12.110 Item 29)
13	-	Front tamper (Not Spared) (REP 12.11-171)
14	-	Rear tamper drive belt (P/O PL 12.110 Item 29)
15	130E12830	Pressing and support encoder sensor (Q12-093)
16	-	Ejector assembly safety cover (P/O PL 31.12 Item 21)
17	130K75900	Paper pressing sensor (Q12-322)
18	127K56551	Motor encoder assembly
19	-	Rear tamper motor (MOT12-227) (P/O PL 12.110 Item 29) (REP 12.15-171)

20	-	Rear tamper (P/O PL 12.110 Item 29)
21	-	Ejector paper present sensor (Q12-202) (P/O PL 12.110 Item 2)
22	033K04850	Ejector paddle assembly (REP 12.58-171)
23	032E35301	Rear tamper arm
24	-	Rear tamper pulley (P/O PL 12.110 Item 29)
25	130E12810	Pressing and support sensor A (Q12-172), B (Q12-171), C (Q12-173)
26	868E36871	Front tamper arm
27	032E35341	Set of front and rear tamper arms
28	003K21101	Pressing plate kit
29	032K09682	Rear tamper assembly (REP 12.15-171)

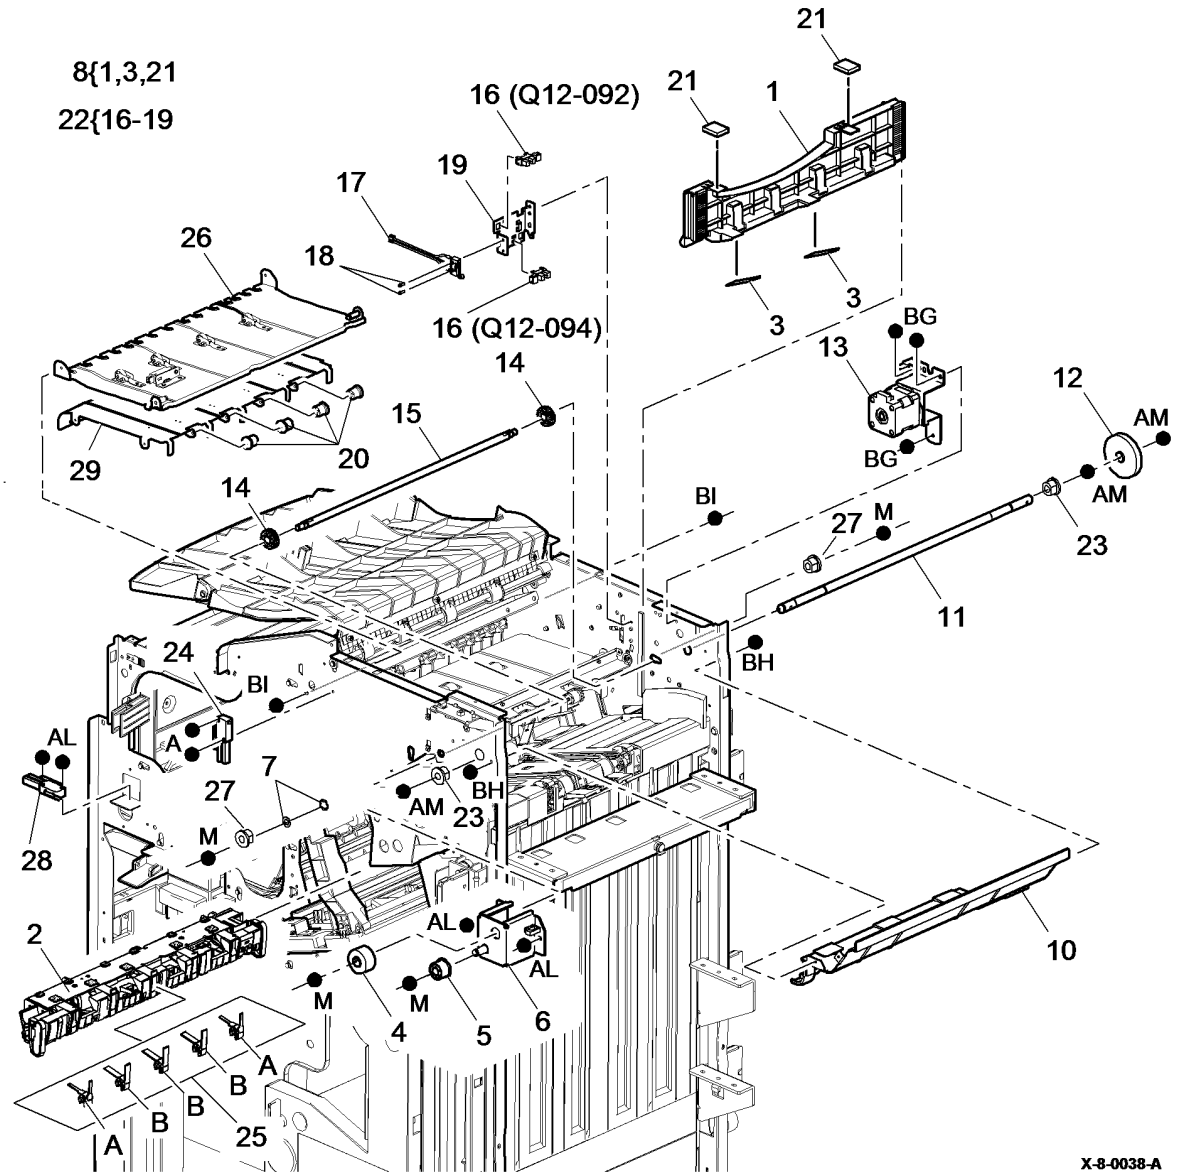
PL 12.115 HVF Ejector, Pressing and Support (3 of 3)

Item	Part	Description
1	-	Paper pusher (P/O PL 12.115 Item 8)
2	033K06101	Paddle unit (REP 12.49-171)
3	-	Pusher mylar (P/O PL 12.115 Item 8)
4	-	Timing belt pulley (Not Spared)
5	-	Timing belt tensioner (Not Spared)
6	-	Front stacker pulley bracket (Not Spared)
7	-	Thrust washer (Not spared)
8	050K68501	Paper pusher assembly (REP 12.53-171)
9	-	Not used
10	-	Compile exit upper guide (Not Spared)
11	-	Stacker main drive gear shaft (Not Spared) (REP 12.37-171)
12	-	Stacker main drive gear (Not Spared) (REP 12.37-171)
13	674K03550	Paper pusher motor assembly (MOT12-265) (REP 12.51-171)
14	-	Pinion gear (Not Spared)
15	-	Pinion gear shaft (Not Spared)
16	130E12830	Paper pusher upper sensor (Q12-092)/Paper pusher lower sensor (Q12-094) (REP 12.54-171)
17	-	Stapler gate safety switch (S12-319) (P/O PL 12.115 Item 22)
18	-	Sensor screw (P/O PL 12.115 Item 22)
19	-	Sensor assembly bracket (P/O PL 12.115 Item 22)
20	006K33390	Stacker idler roll (REP 12.10-171)

21	-	Pusher dampers (P/O PL 12.115 Item 8)
22	674K03541	Sensor assembly (REP 12.54-171)
23	013E37150	Stacker driving shaft bearing (REP 12.37-171)
24	110K13970	Top cover interlock switch (S12-197)
25	033K04651	Paddles (A) outer 2 off, (B) inner 3 off (REP 12.9-171)
26	059K69932	Top jam clearance guide assembly
27	013E25800	Copper bearing
28	110K13980	Front door interlock switch (S12-303)
29	-	Lower exit guide (Not Spared)

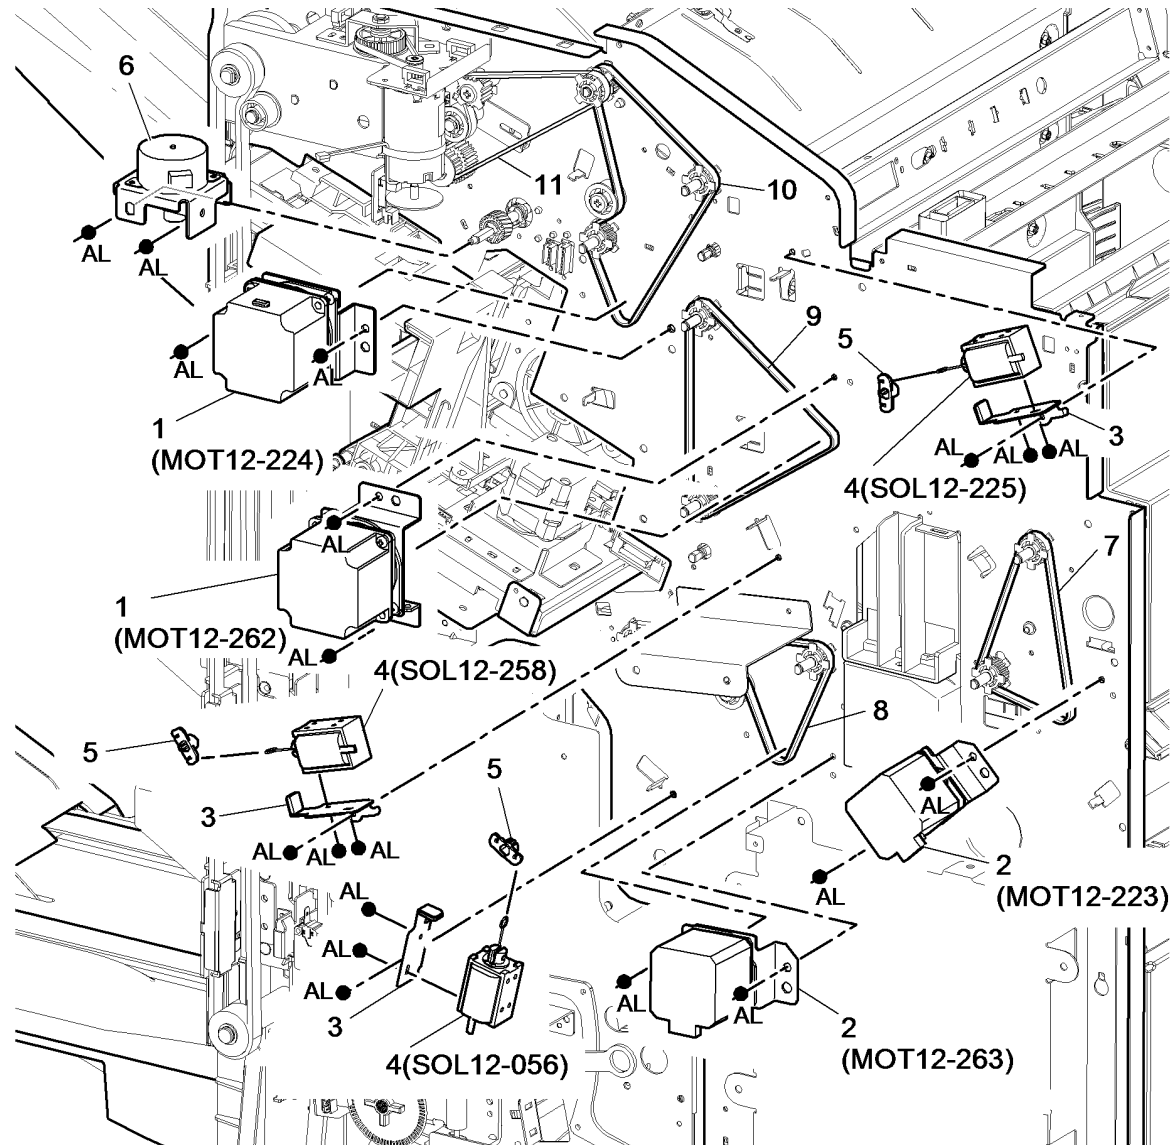
PL 12.120 HVF Main Drives

Item	Part	Description
1	127K56570	Buffer motor (MOT12-262) (REP 12.65-171)/Transport motor 2 (MOT12-224) (REP 12.66-171)
2	127K56560	Transport motor 1 (MOT12-223) (REP 12.63-171)/Bypass feed motor (MOT12-263) (REP 12.64-171)
3	-	Solenoid bracket (P/O PL 12.120 Item 4)
4	121K45290	BM diverter solenoid (SOL12-258)/Exit diverter solenoid (SOL12-225)/Set clamp solenoid (SOL12-056)
5	-	Solenoid connector (Not Spared)
6	127K56610	Paddle unit motor assembly (MOT12-239) (REP 12.48-171)
7	-	Transport motor 1 drive belt (Not Spared)
8	-	Bypass feed motor drive belt (Not Spared)
9	-	Buffer feed motor drive belt (Not Spared)
10	-	Transport motor 2 drive belt (A) (Not Spared)
11	-	Transport motor 2 drive belt (B) (Not Spared)

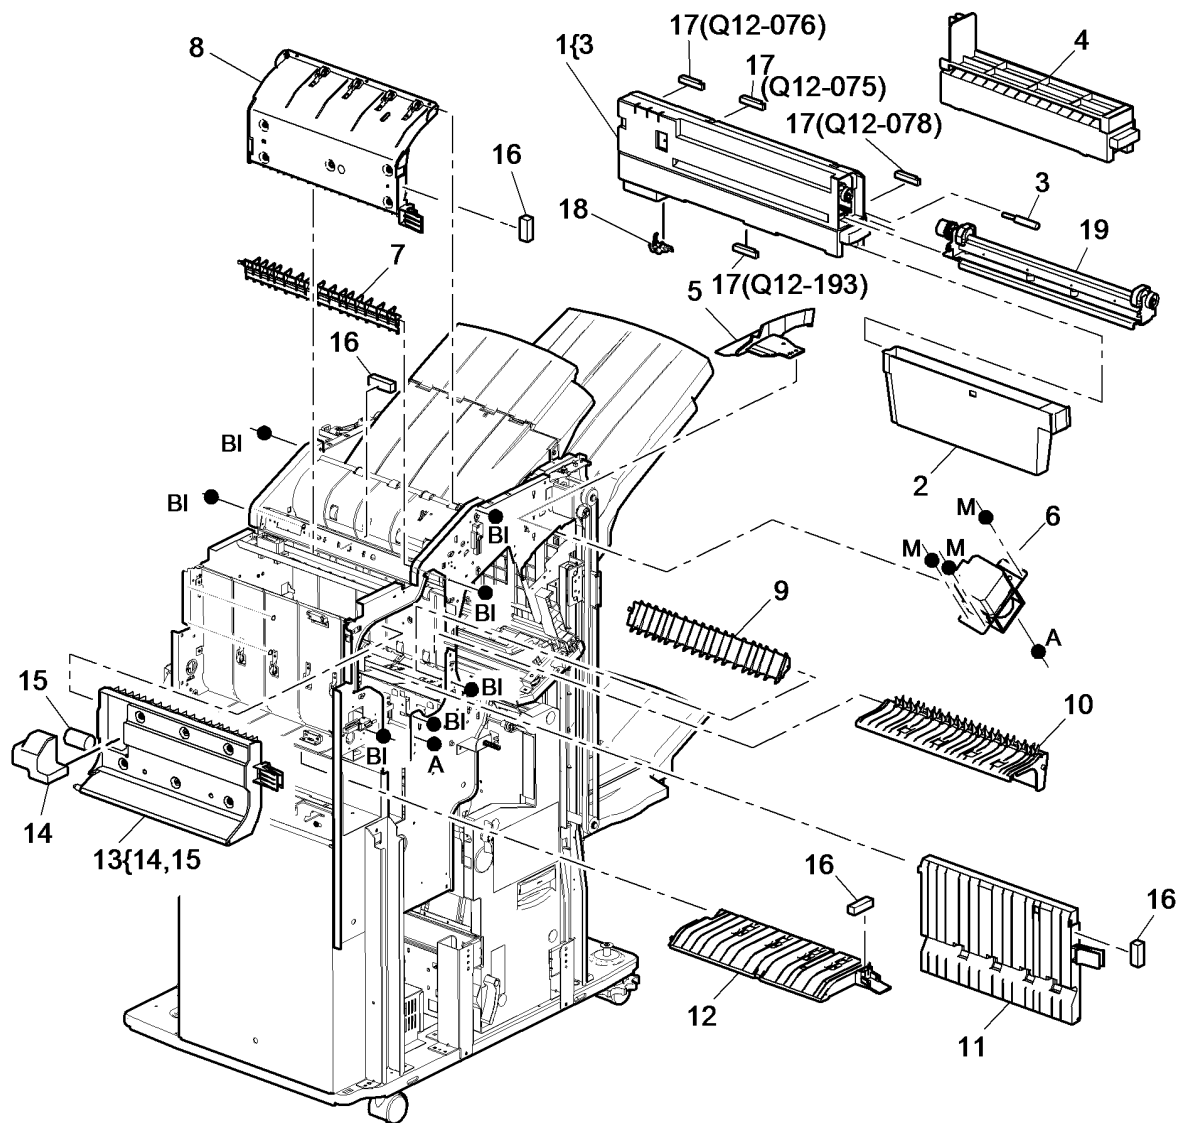
PL 12.125 HVF Feed Assembly and Punch (1 of 3)

Item	Part	Description
1	604K55211	HVF hole punch carrier assembly
2	604K83750	HVF chad bin
3	-	Hole punch thumb screw (P/O PL 12.125 Item 1)
4	059K59551	Hole punch blanking assembly
5	-	Front tamper arm (Not Spared)
6	127K62570	Front tamper motor assembly (MOT12-226) (REP 12.11-171)
7	038E41350	Diverter exit gate (REP 12.35-171)
8	-	Upper exit guide (5c) (Not Spared) (REP 12.14-171)
9	038E41341	BM diverter gate (REP 12.39-171)
10	059K69950	Buffer pocket jam clearance guide (REP 12.33-171)
11	059K69982	Inserter jam clearance guide assembly (8a) (REP 12.34-171)
12	859K19430	Input jam clearance guide (5a) (REP 12.32-171)
13	059K69974	Buffer guide assembly (5b) (REP 12.31-171)
14	-	Nip split motor cover (P/O PL 12.125 Item 13)
15	-	Nip split motor (MOT12-264) (P/O PL 12.125 Item 13)
16	121K45300	Magnet
17	130E12810	Chad bin level sensor (Q12-193)/Punch sensor 1 (Q12-078)/Punch sensor 2 (Q12-075)/Punch sensor 3 (Q12-076)

18	130E12840	Chad bin present sensor (Q12-118)
19	-	Hole punch module (P/O PL 31.11 Item 2)

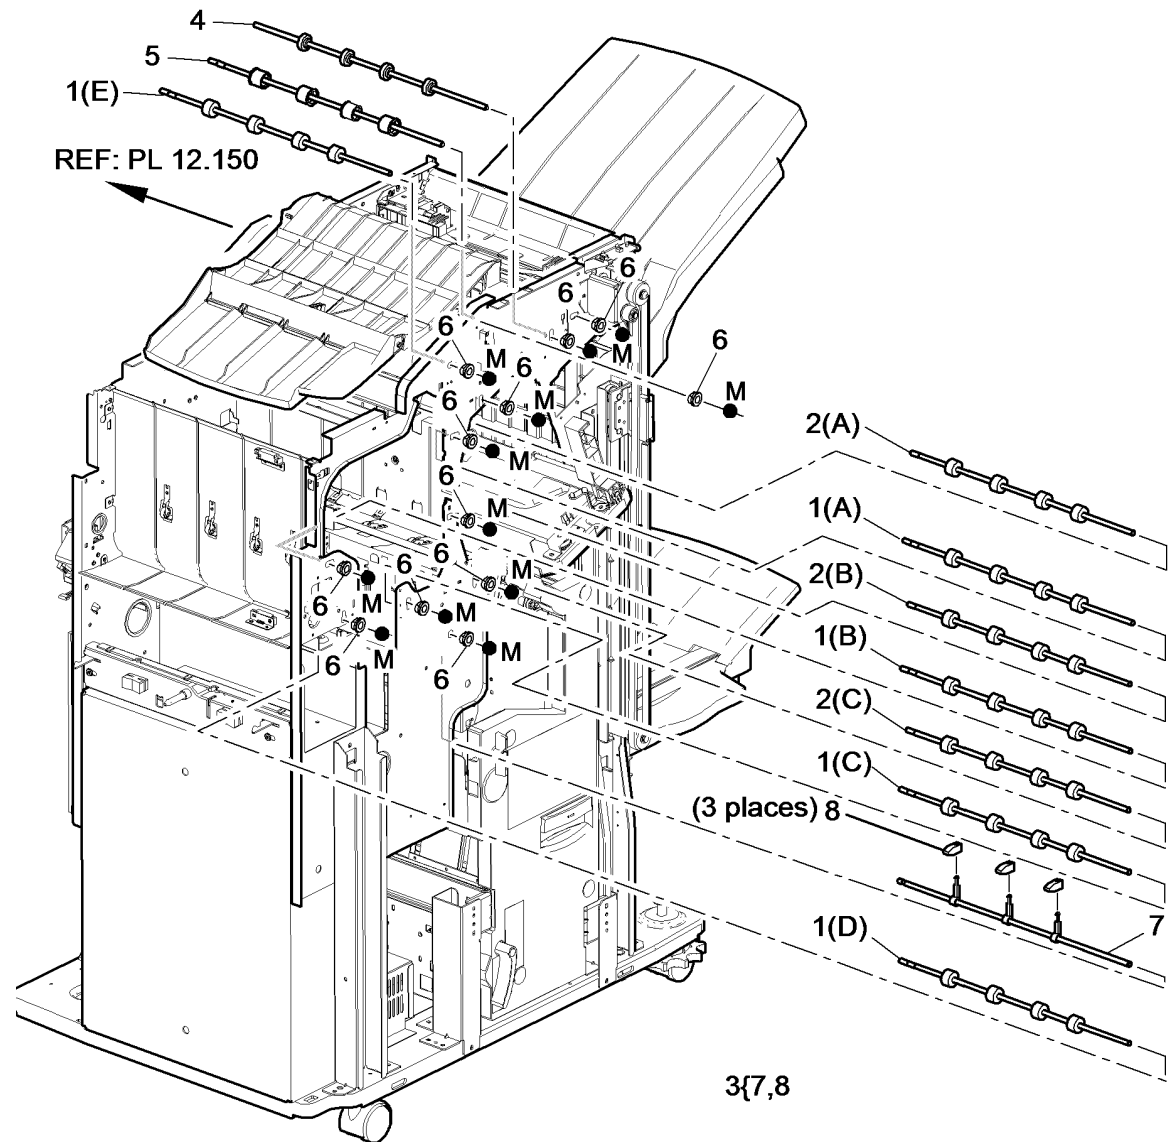
PL 12.130 HVF Feed Assembly and Punch (2 of 3)

Item	Part	Description
1	006K32841	Feed roll assembly (Short shaft type)
-	-	Buffer upper roll (1A) (REP 12.45-171)
-	-	Inserter guide roll (1B) (REP 12.41-171)
-	-	Buffer pocket roll (1C) (REP 12.42-171)
-	-	Input roll (1D) (REP 12.40-171)
-	-	Top exit feed roll (1E) (REP 12.47-171)
2	006K32850	Feed roll assembly
-	-	Stacker exit feed roll (2A) (REP 12.46-171)
-	-	Buffer lower roll (2B) (REP 12.44-171)
-	-	Booklet entrance roll (2C) (REP 12.43-171)
3	019K13660	Buffer clamp assembly
4	006K32820	Stacker exit roll
5	006K32810	Top exit roll
6	013E25800	Copper bearing
7	-	Buffer clamp shaft (P/O PL 12.130 Item 3)
8	019K14420	Buffer clamp

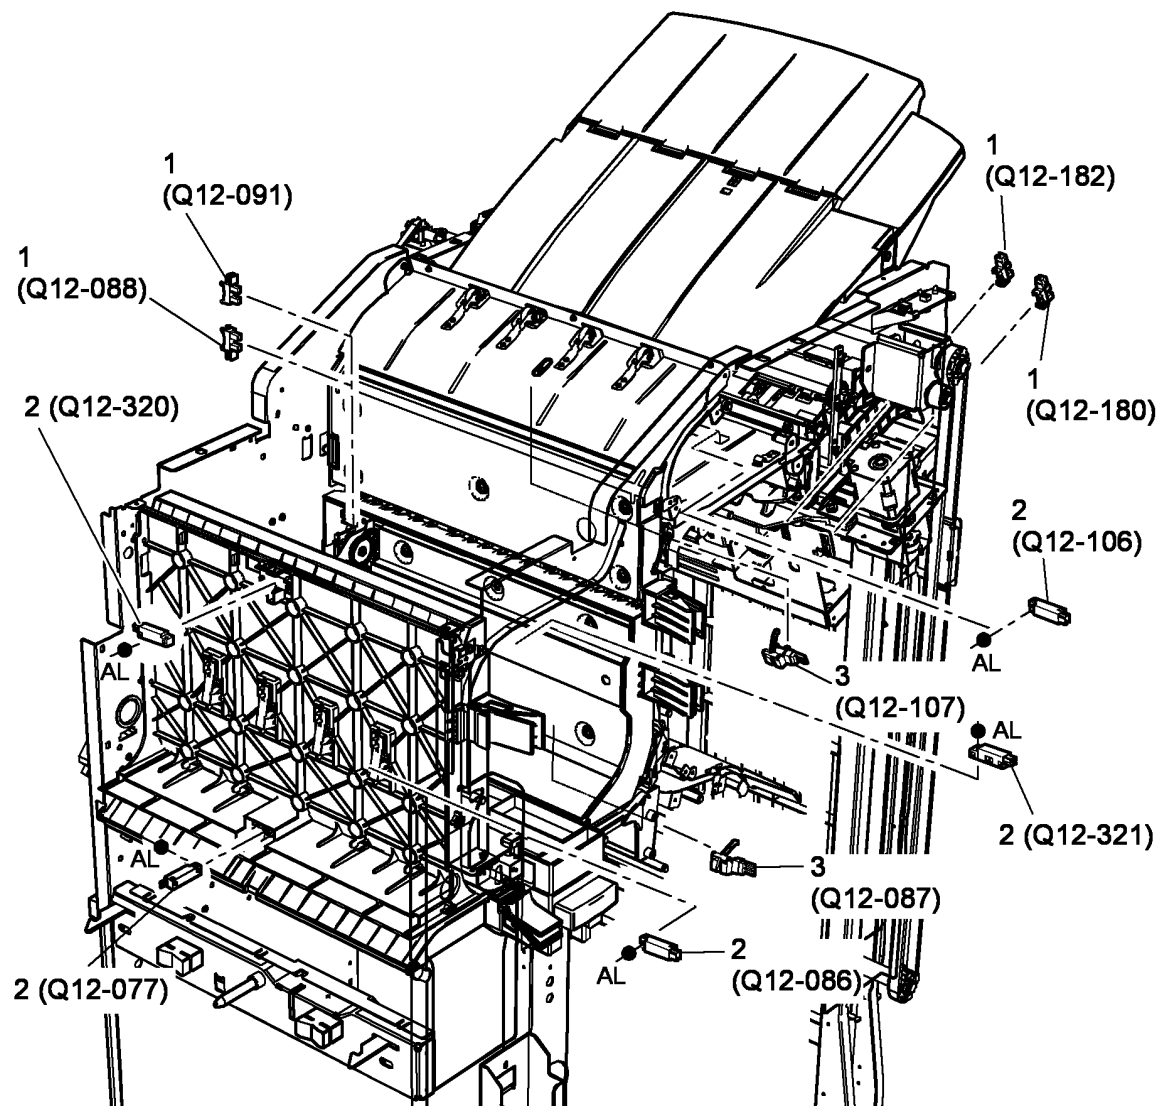
PL 12.135 HVF Feed Assembly and Punch (3 of 3)

Item	Part	Description
1	130E12830	Tamper front home sensor (Q12-180)/Tamper front away sensor (Q12-182)/Nip split sensor (Q12-091)/Nip home sensor (Q12-088)
2	130E12810	Entry sensor (Q12-077)/Compiler exit sensor (Q12-106)/Buffer position sensor (Q12-086)/Buffer path sensor (Q12-321)/Inserter standby sensor (Q12-320)
3	130E12840	Top tray exit sensor (Q12-107)/HVF Booklet exit sensor (Q12-087)
