708P91368
September 2017

Xerox® AltaLink® B8090 Family Multifunction Printer Service Manual

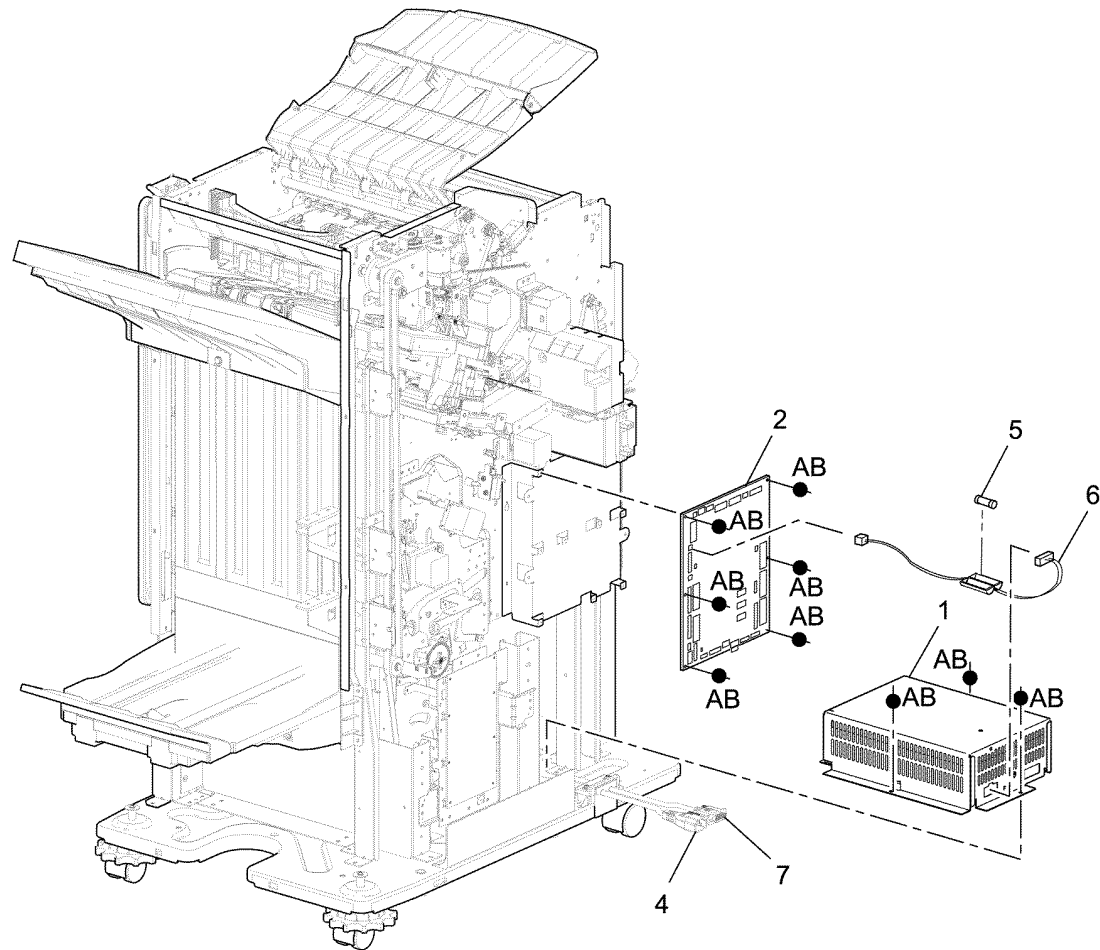
PL 12.140 HVF Power and Control

Item	Part	Description
1	105K35831	HVF power supply unit (REP 12.55-171)
2	960K97490	HVF PWB (REP 12.57-171)
3	-	Not used
4	105K40140	Power cord
5	-	In-line fuse (10A slo-blow) (Not Spared)
6	-	Harness (Not Spared)
7	952K00411	Power communications cable

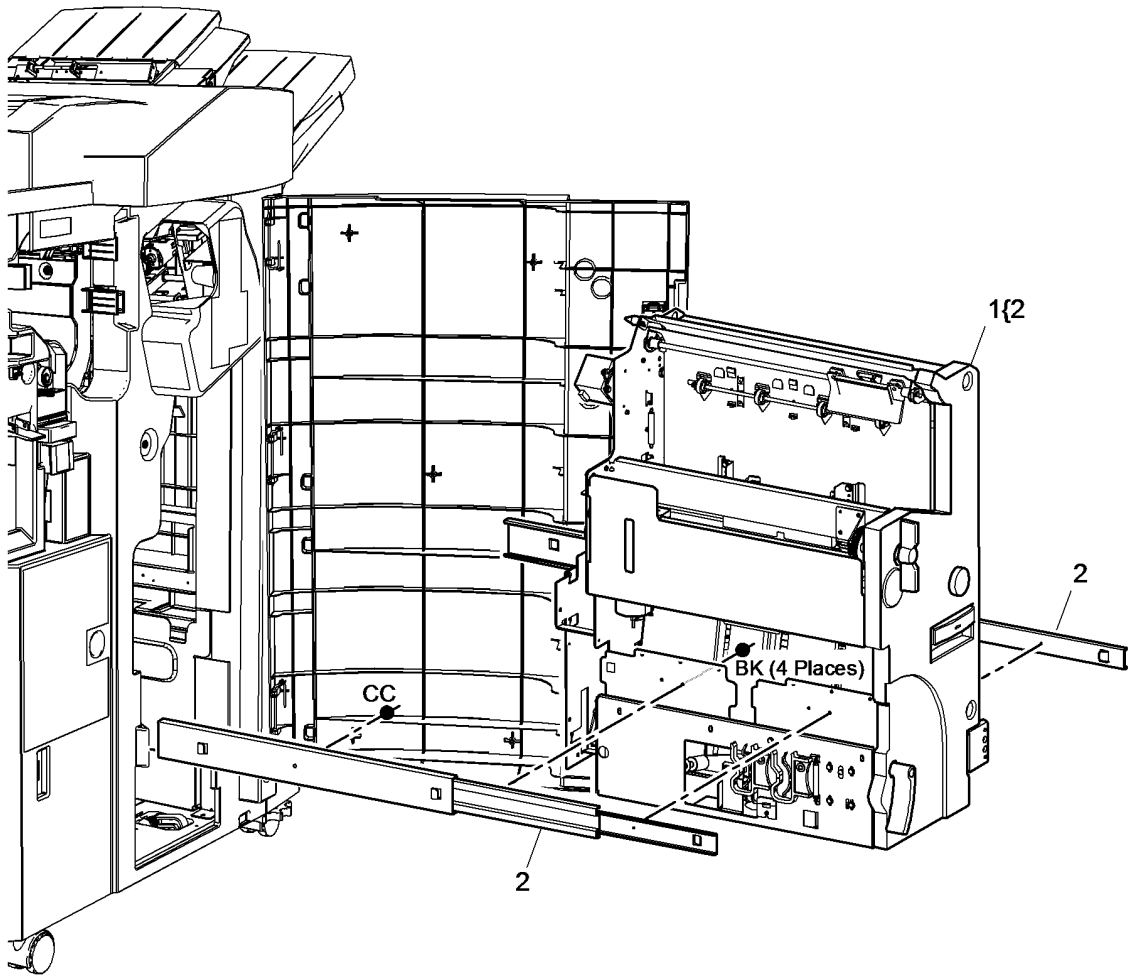
PL 12.145 HVF BM Module (Complete)

Item	Part	Description
1	084K37050	BM Module (REP 12.61-171)
2	-	Slide assembly (Not Spared) (REP 12.62-171)

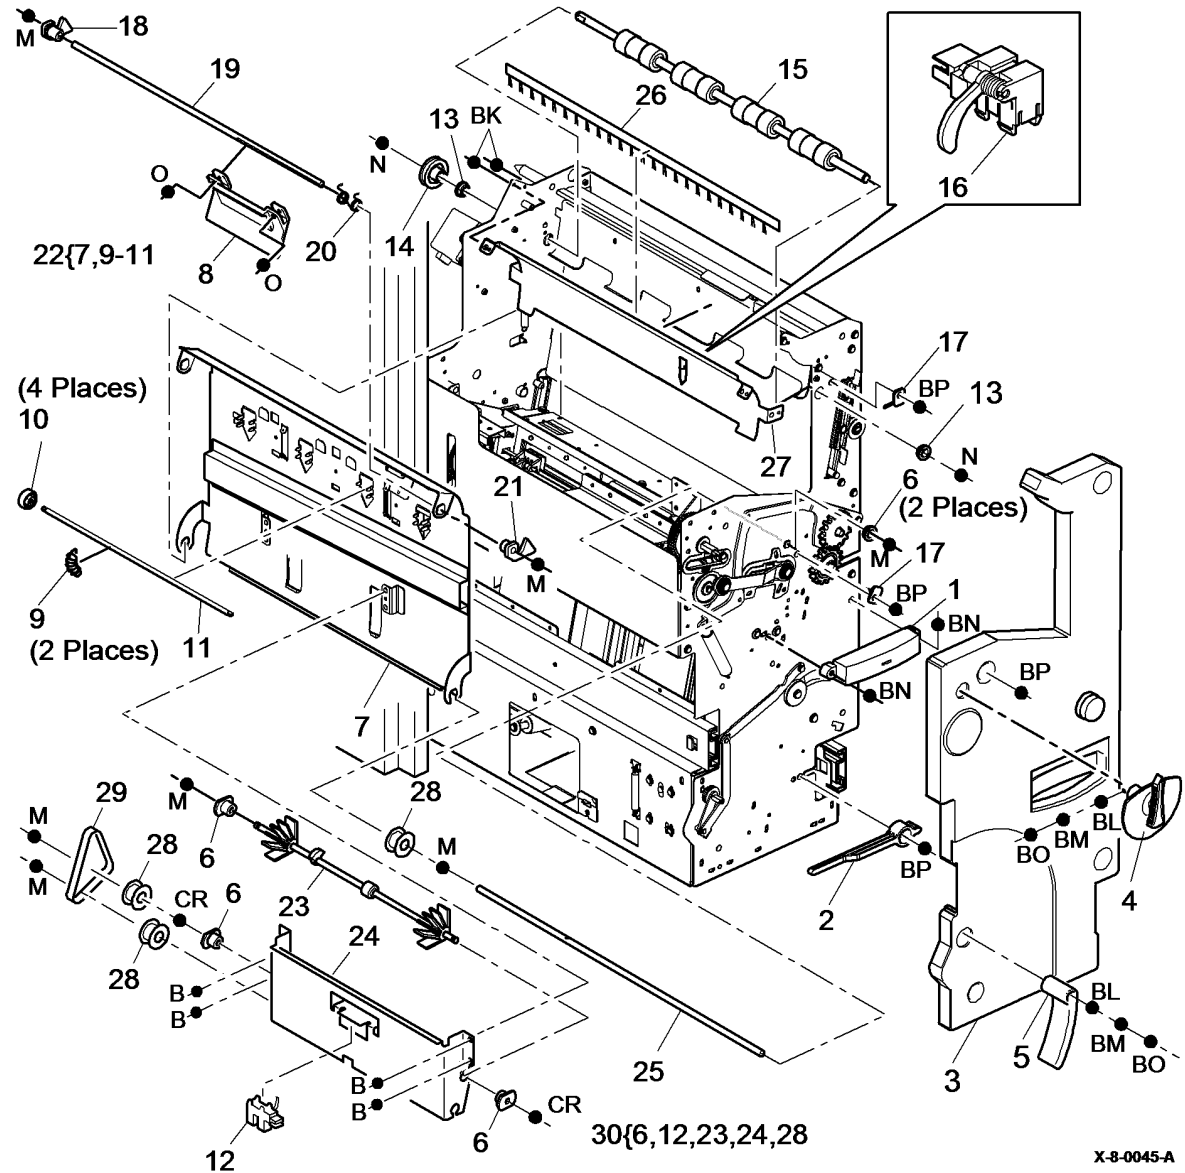
PL 12.150 HVF BM Entry and Front Cover

Item	Part	Description
1	003E69093	Drawer handle
2	-	Crease roll leaf spring (Not Spared)
3	848E40470	BM Front cover
4	803E14111	Crease blade knob (6d)
5	803E13851	Crease roll handle (6c)
6	013E12610	Nylon bearing
7	-	Paper guide (6e) (P/O PL 12.150 Item 22) (REP 12.60-171)
8	-	Jam clearance handle (Not Spared)
9	-	Nip spring (P/O PL 12.150 Item 22) (REP 12.60-171)
10	022E30620	Nip roll (REP 12.60-171)
11	-	Nip shaft (P/O PL 12.150 Item 22) (REP 12.60-171)
12	130K74072	Flapper home sensor (Q12-207) (REP 12.16-171)
13	-	Bearing (Not Spared)
14	020E39990	BM Entry roll pulley (REP 12.22-171)
15	006K28660	BM Entry roll (REP 12.22-171)
16	130K74110	BM Entry sensor (Q12-089) (REP 12.23-171)
17	125E00430	Static eliminator
18	-	Rear latch (Not Spared)
19	-	Shaft (Not Spared)
20	809E46411	Latch spring
21	-	Front latch (Not Spared)
22	-	Entrance baffle assembly (Not Spared) (REP 12.60-171)
23	-	BM Flapper (P/O PL 12.150 Item 30) (REP 12.16-171)

24	-	BM flapper bracket (P/O PL 12.150 Item 30)
25	-	BM Compiler shaft (Not Spared)
26	125K03831	Static eliminator
27	-	Top baffle (Not Spared)
28	-	Pulley (Not Spared)
29	-	BM flapper drive belt (Not Spared)
30	059K52940	BM Flapper assembly (REP 12.16-171)

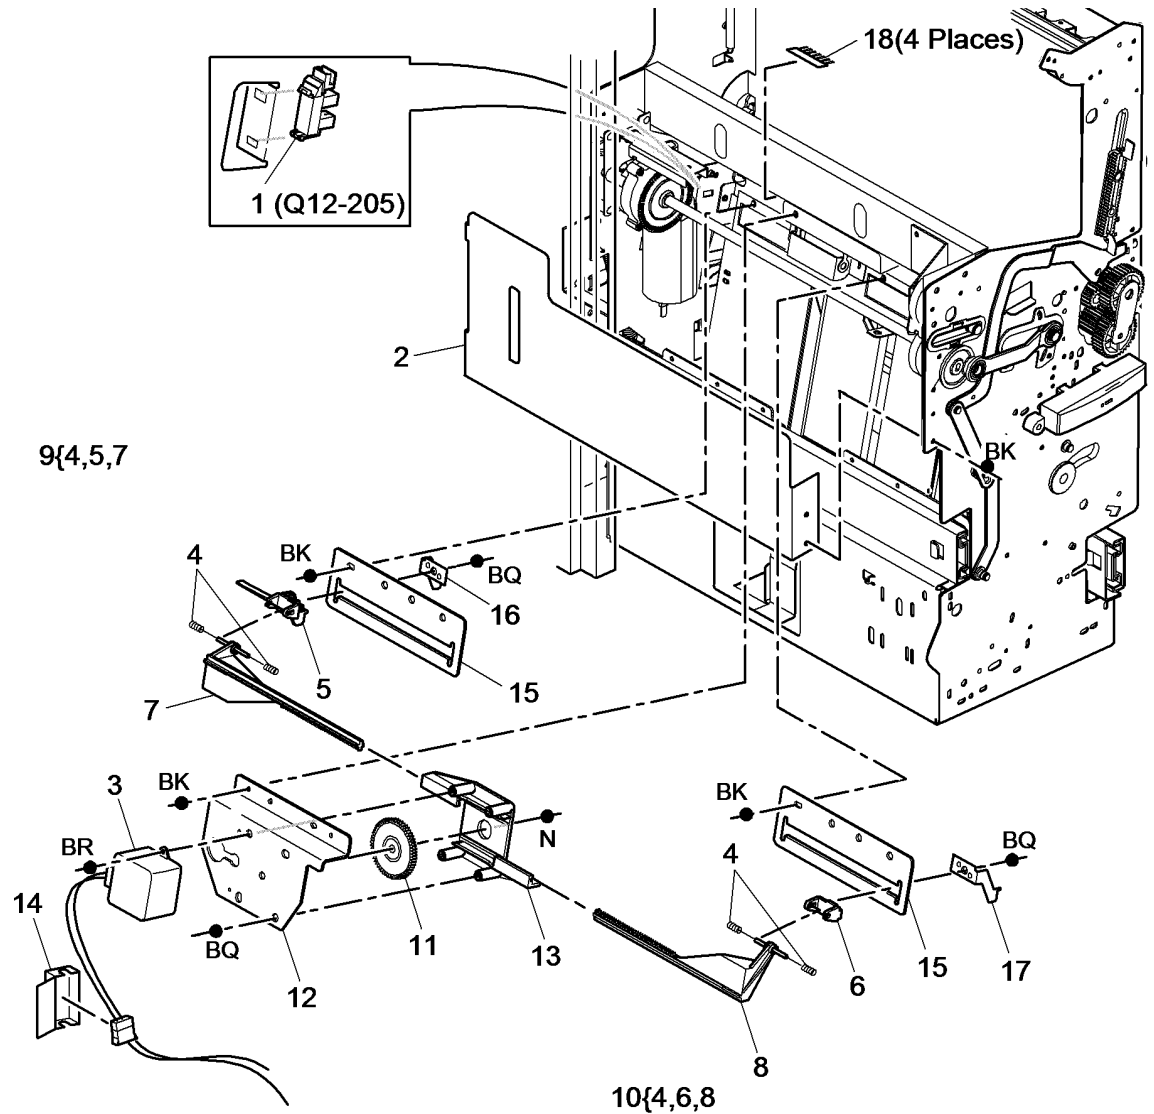
PL 12.155 HVF BM Tamper Assembly

Item	Part	Description
1	107E22600	BM Tamper 1 home sensor (Q12-205)
2	-	LH Frame plate (Not Spared)
3	127K47660	BM Tamper 1 motor (MOT12-256) (REP 12.30-171)
4	-	BM Tamper spring (P/O PL 12.155 Item 10)
5	-	BM Rear tamper arm (P/O PL 12.155 Item 9) (REP 12.30-171)
6	-	BM Front tamper arm (P/O PL 12.155 Item 10) (REP 12.30-171)
7	-	BM Rear tamper rack (P/O PL 12.155 Item 9) (REP 12.30-171)
8	-	BM Front tamper rack (P/O PL 12.155 Item 10) (REP 12.30-171)
9	007K13190	BM Rear tamper assembly (REP 12.30-171)
10	007K13180	BM Front tamper assembly (REP 12.30-171)
11	807E15450	BM Tamper gear (REP 12.30-171)
12	-	BM Tamper bracket (Not Spared) (REP 12.30-171)
13	-	BM Tamper rack guide (Not Spared) (REP 12.30-171)
14	802E59410	BM Connector cover
15	-	BM Tamper guide plate (Not Spared) (REP 12.30-171)
16	-	BM Rear tamper finger (Not Spared) (REP 12.30-171)
17	-	BM Front tamper finger (Not Spared) (REP 12.30-171)
18	125K03593	BM Static eliminator

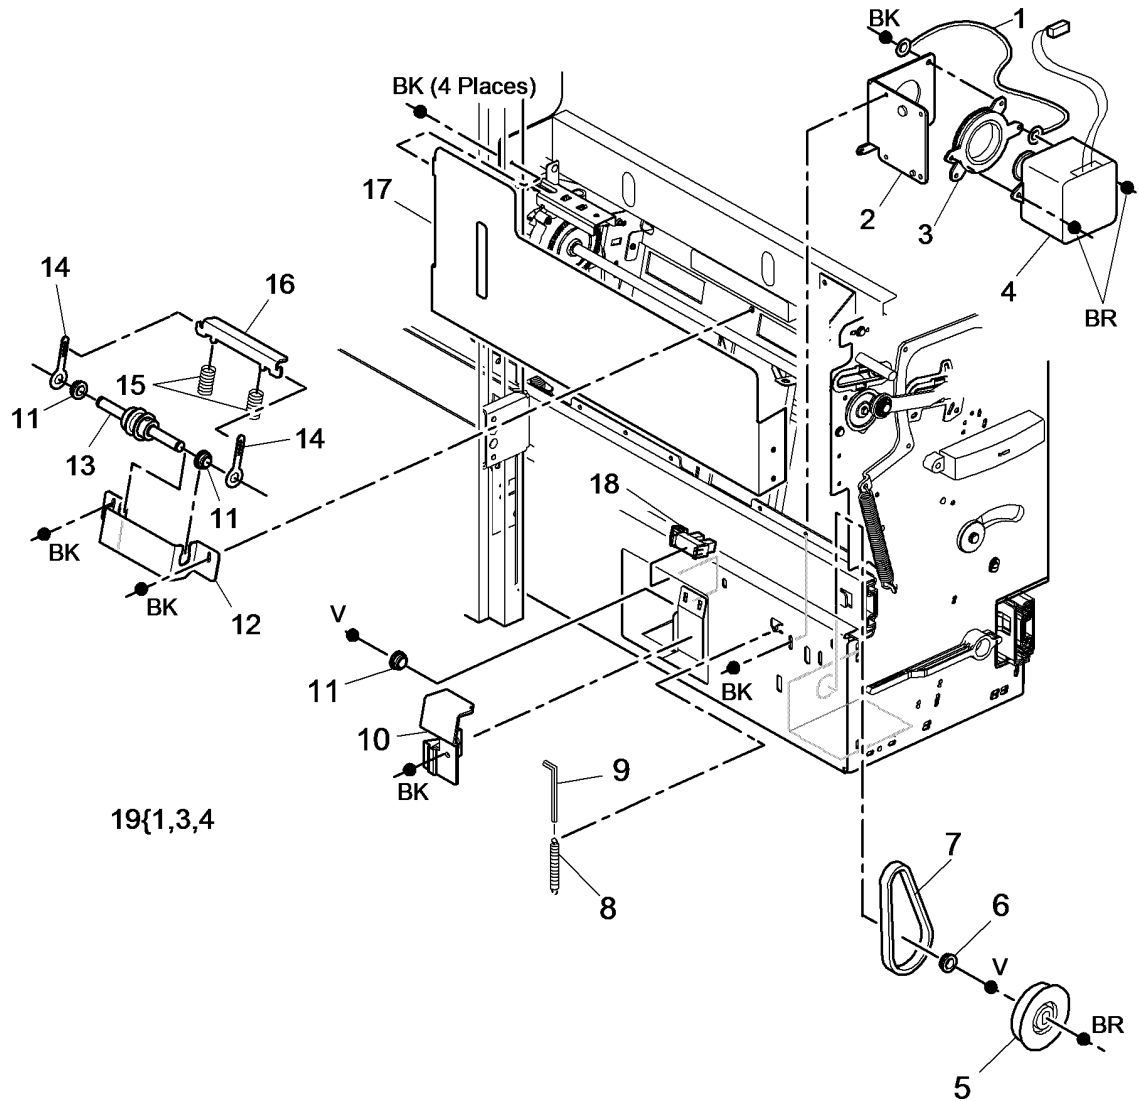
PL 12.160 HVF BM Back Stop Motor

Item	Part	Description
1	-	Ground wire (P/O PL 12.160 Item 19)
2	-	Motor bracket (Not spared)
3	-	Motor damper (P/O PL 12.160 Item 19) (REP 12.20-171)
4	-	BM back stop motor (MOT12-255) (P/O PL 12.160 Item 19) (REP 12.20-171)
5	-	Pulley (Not Spared)
6	-	BM back stop bearing (Not Spared) (REP 12.26-171)
7	023E23300	BM back stop drive belt (REP 12.20-171)
8	809E78370	BM back stop tensioner spring (REP 12.20-171)
9	-	Allen key (3mm) (Not spared)
10	848E40480	Sensor cover
11	-	BM back stop bearing (Not Spared) (REP 12.26-171)
12	-	BM back stop idler bracket (Not Spared) (REP 12.26-171)
13	-	BM back stop idler shaft (Not Spared)
14	-	BM back stop tensioner link (Not Spared)
15	809E25100	BM back stop link spring (REP 12.26-171)
16	012E20870	BM back stop link (REP 12.26-171)
17	-	LH frame plate (Not spared)
18	107E22600	BM guide home sensor (Q12-204)
19	127K54710	BM back stop motor assembly (REP 12.20-171)

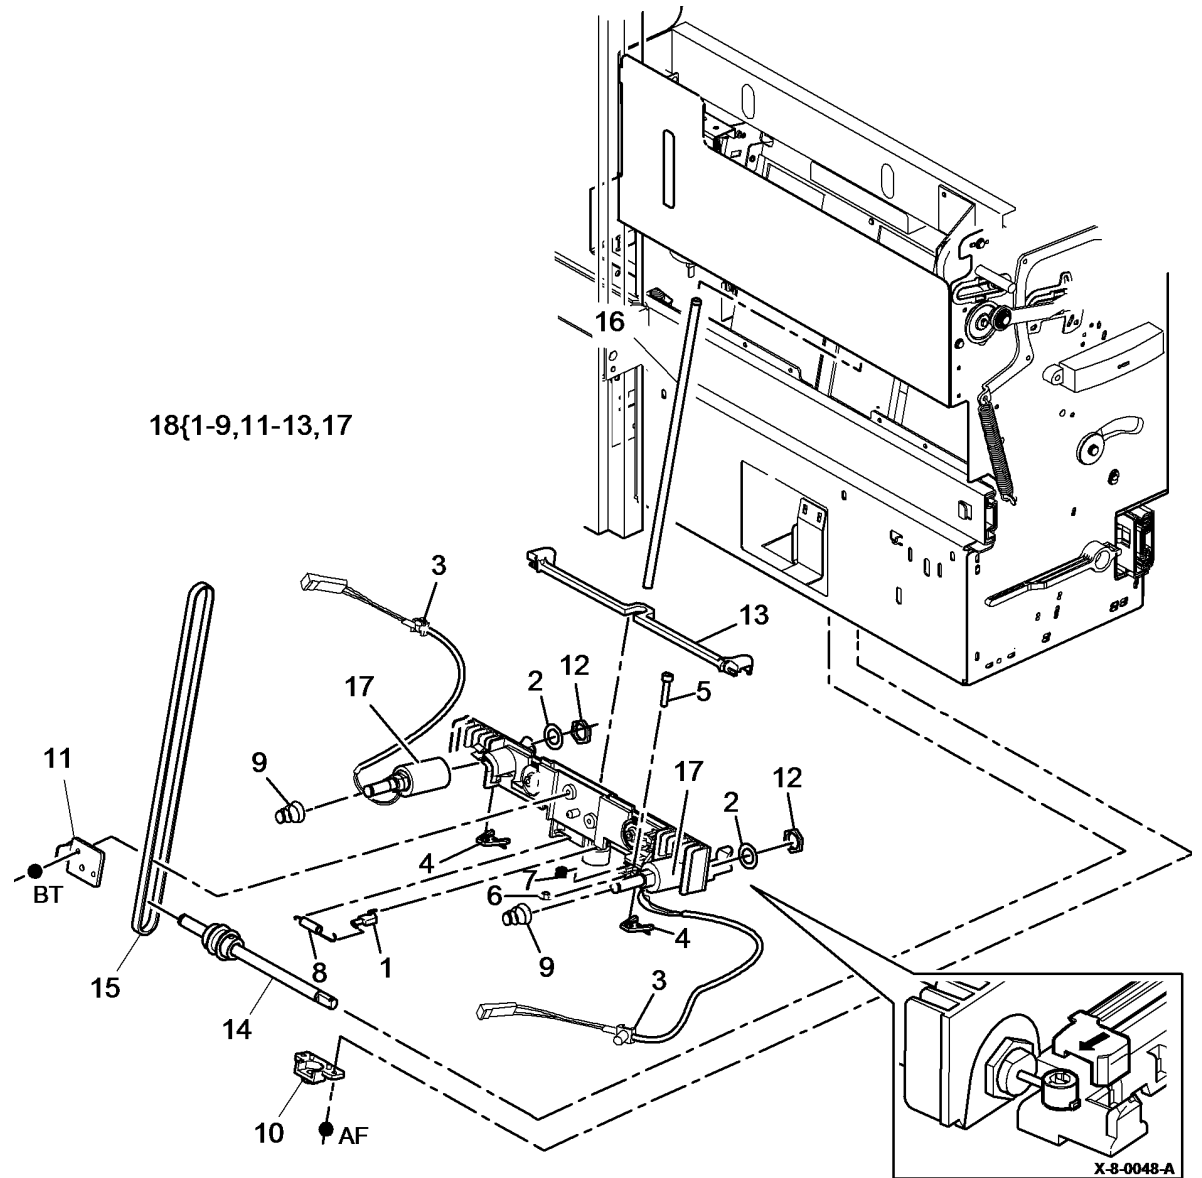
PL 12.165 HVF BM Back Stop Assembly

Item	Part	Description
1	019E74451	Anti-play shoe
2	-	BM back stop lock washer (P/O PL 12.165 Item 18)
3	-	Cable fastener (P/O PL 12.165 Item 18)
4	031E11300	Anti-rattle arm
5	-	Screw (P/O PL 12.165 Item 18)
6	-	Flanged hex nut (P/O PL 12.165 Item 18)
7	-	Back stop adjust spring (P/O PL 12.165 Item 18)
8	809E71970	Antiplay spring
9	-	Solenoid spring (P/O PL 12.165 Item 18)
10	-	Shaft support (Not Spared)
11	-	Belt clamp (P/O PL 12.165 Item 18)
12	-	BM back stop solenoid nut (P/O PL 12.165 Item 18)
13	-	Pivoting clamp (P/O PL 12.165 Item 18)
14	006K30790	BM back stop drive shaft (REP 12.26-171)
15	023E23140	BM back stop belt (REP 12.26-171)
16	-	BM back stop shaft (Not Spared)
17	-	BM stack hold solenoid (SOL12-259) (P/O PL 12.165 Item 18)
18	019K14160	BM back stop assembly (REP 12.21-171)

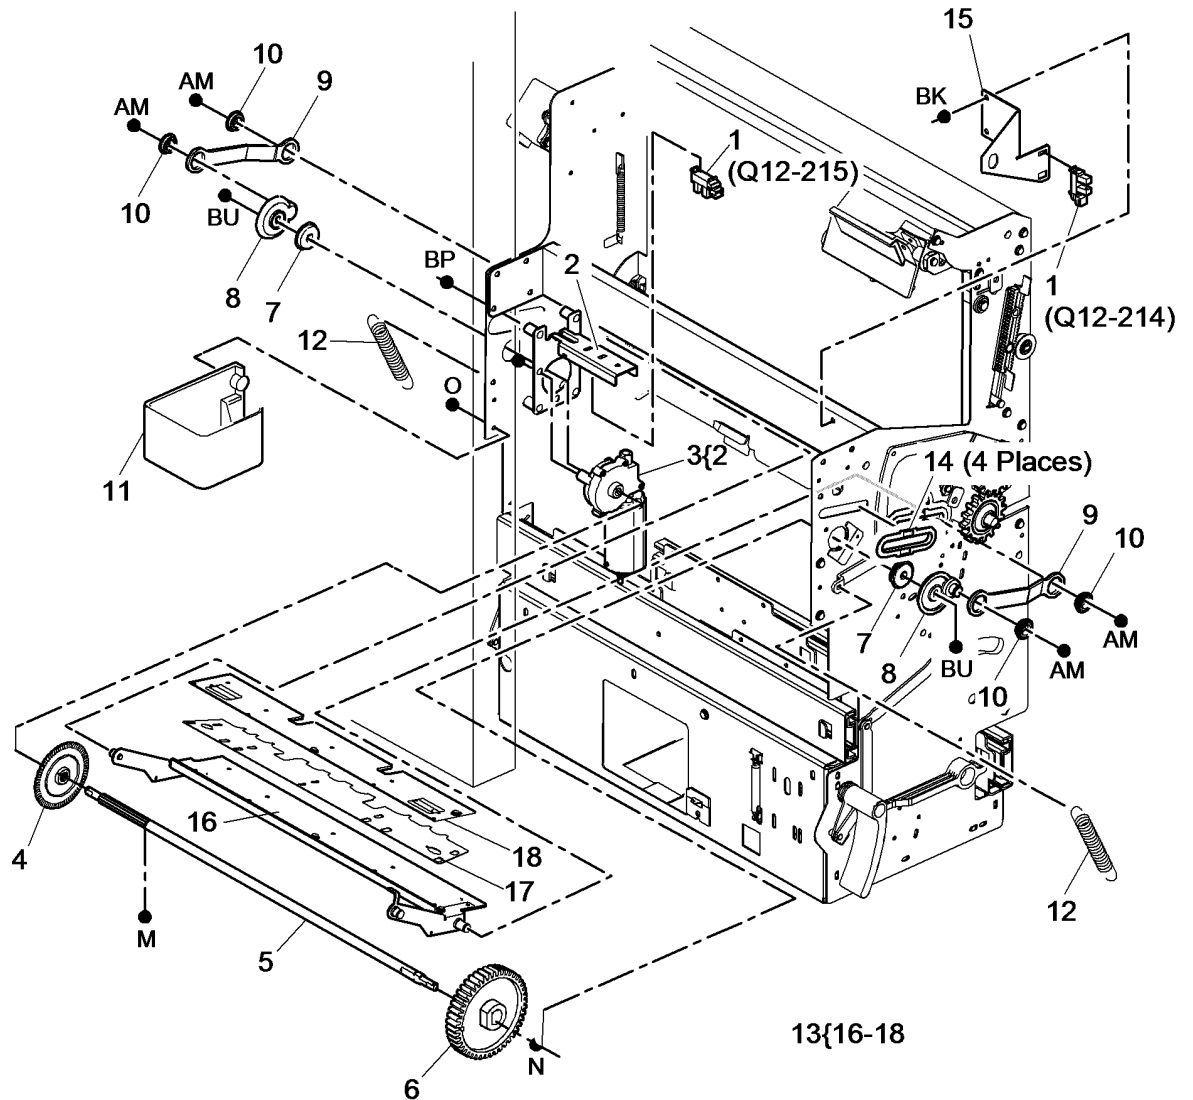
PL 12.170 HVF BM Crease Blade Motor

Item	Part	Description
1	107E22600	BM Crease blade motor encoder sensor (Q12-215), BM Crease blade home sensor (Q12-214) (REP 12.18-171)
2	-	Motor bracket (P/O PL 12.170 Item 3)
3	127K54690	BM Crease blade motor assembly (MOT12-252) (REP 12.18-171)
4	014E47460	Motor encoder (REP 12.18-171)
5	806E36200	Drive shaft
6	007E69830	Drive gear (40T)
7	413W30654	Bearing (REP 12.18-171)
8	008E08220	Crank (REP 12.18-171)
9	012E20860	Connecting rod (REP 12.36-171)
10	-	Bearing (Not Spared)
11	802E59171	Motor cover
12	809E42861	Crease nip spring
13	-	Crease blade assembly (Not Spared) (REP 12.36-171, ADJ 12.4-171)
14	032E19330	Crease blade support guide (REP 12.36-171)
15	-	Crease blade home sensor bracket (Not spared)
16	-	Lower mounting plate (P/O PL 12.170 Item 13)
17	815E56520	Crease blade folder plate
18	-	Upper mounting plate (P/O PL 12.170 Item 13)

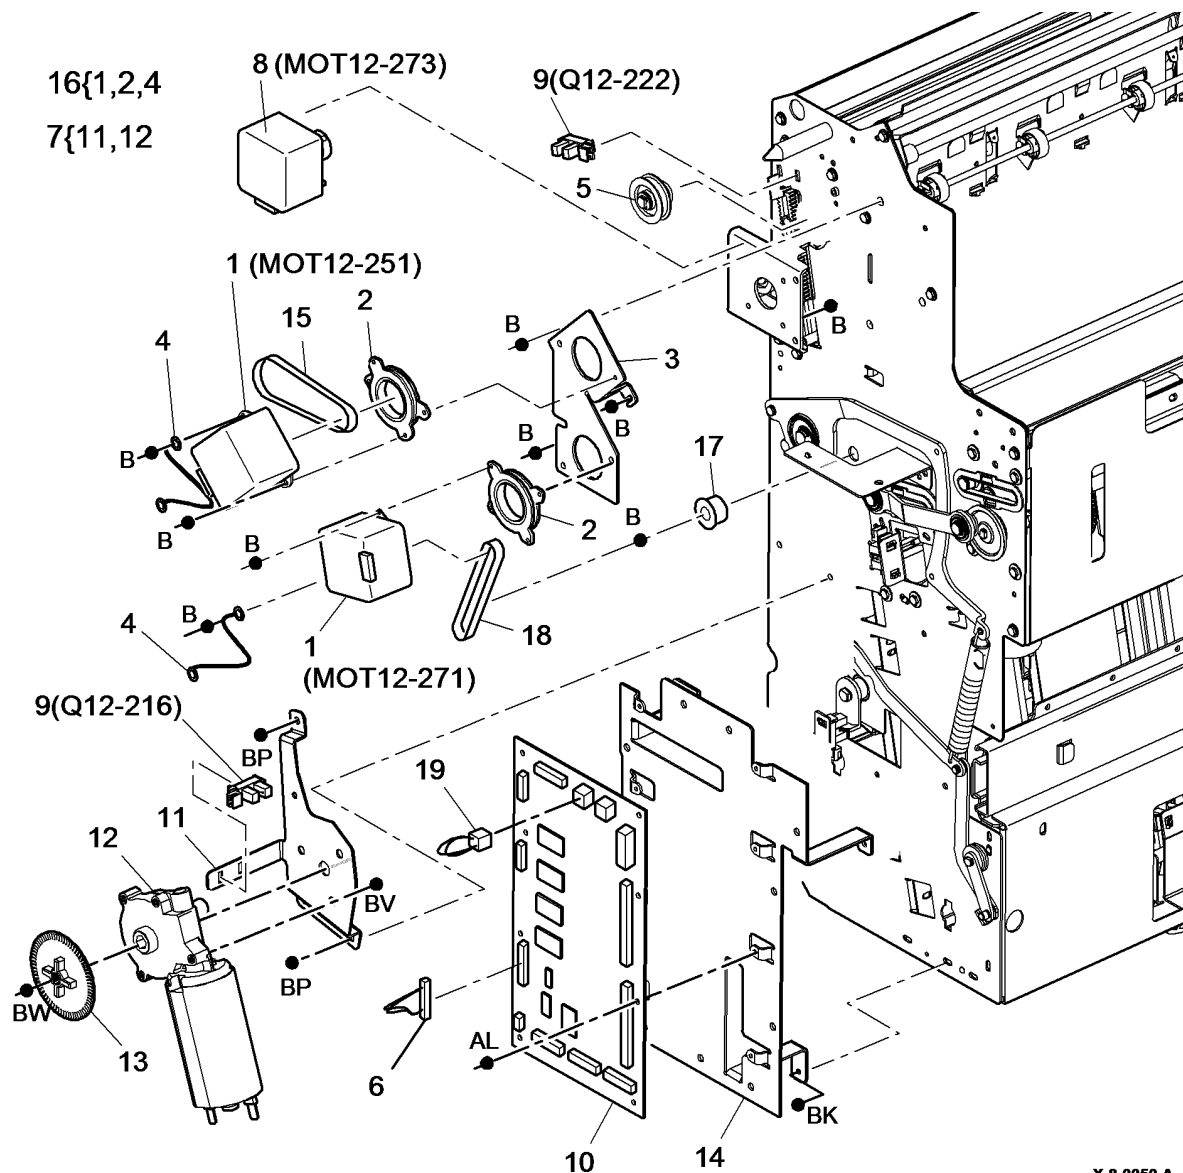
PL 12.175 HVF BM Crease Rolls Motor and PWB

Item	Part	Description
1	127K43751	BM compiler motor (MOT12-251)/ BM flapper motor (MOT12-271) (REP 12.25-171)
2	-	Damper bracket (P/O PL 12.175 Item 16) (REP 12.25-171)
3	-	Motor bracket (Not Spared)
4	-	Ground wire (P/O PL 12.175 Item 16)
5	007E69000	Gear (50T)/pulley (24T)
6	-	Tri-folder logic cheat (PJ563) (Not Spared)
7	127K54680	BM Crease roll motor assembly
8	127K53620	BM crease roll gate motor (MOT12- 273) (REP 12.24-171)
9	107E22600	BM Crease roll gate home sensor (Q12-222), BM Crease roll motor encoder sensor (Q12-216)
10	960K52781	BM PWB (REP 12.17-171)
11	-	Motor bracket (P/O PL 12.175 Item 12)
12	127K62560	BM Crease roll motor (MOT12-253) (REP 12.19-171)
13	014E47460	BM Crease roll motor encoder
14	-	Support bracket (Not Spared)
15	023E25430	Compiler motor belt
16	127K55520	BM Compiler motor assembly (REP 12.25-171)
17	-	BM flapper motor pulley (Not Spared)
18	-	BM flapper motor drive belt (Not Spared)

19	-	Tri-folder interlock cheat (PJ553) (Not Spared)

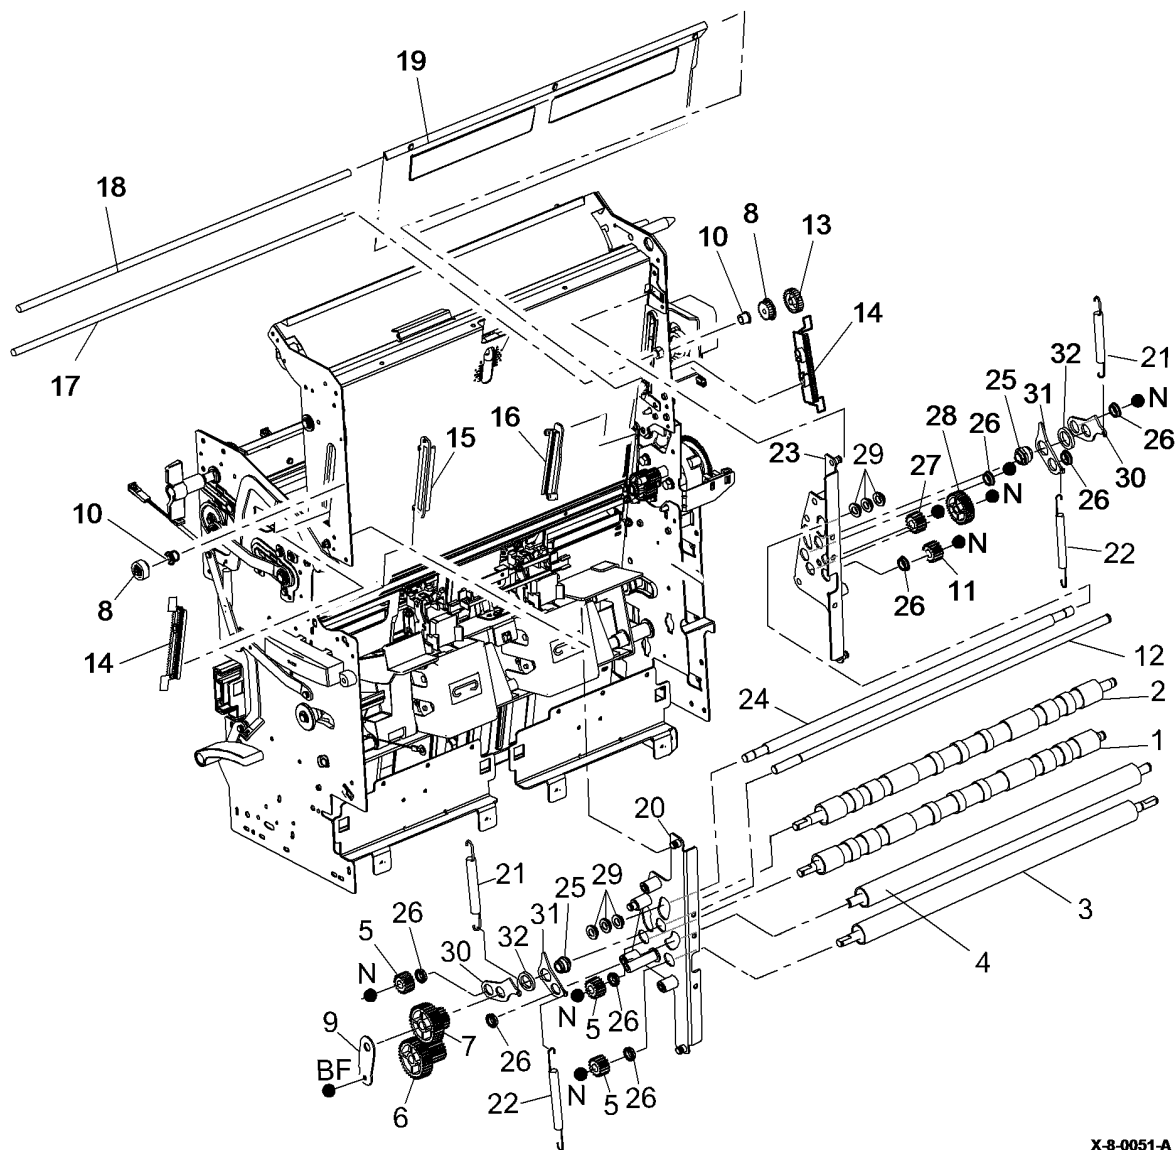
PL 12.180 HVF BM Crease Rolls and Support Leg

Item	Part	Description
1	006K32721	Crease roll assembly 1 (REP 12.52-171)
2	006K32731	Crease roll assembly 2 (REP 12.52-171)
3	006K32740	Crease roll assembly 3 (REP 12.52-171)
4	006K32750	Crease roll assembly 4 (REP 12.52-171)
5	807E34231	Gear crease roll 4
6	807E34240	Lower compound gear
7	807E34280	Upper compound gear
8	007E69081	Crease roll gate rack gear (REP 12.59-171)
9	-	Gear plate (Not Spared)
10	-	Bearing (Not Spared)
11	807E34261	Gear (16T)
12	-	Drive shaft (Not Spared)
13	007E69070	Crease roll gate rack drive gear (REP 12.59-171)
14	007E68951	Crease roll gate rack (REP 12.59-171)
15	020E54110	Crease roll gate front guide (REP 12.59-171)
16	020E54120	Crease roll gate rear guide (REP 12.59-171)
17	-	Crease roll drive shaft (Not Spared)
18	-	Crease roll gate shaft (Not Spared)
19	050E23160	Crease roll gate (REP 12.59-171)
20	-	Front frame assembly (Not Spared)
21	809E95060	Spring arm nip 1
22	809E95071	Spring arm nip 2

23	-	Rear frame assembly (Not spared)
24	-	Nip release shaft (Not Spared)
25	016E20010	Bush roll release
26	413W88650	Bearing flanged
27	807E34251	Gear (15T)
28	807E34270	Gear (30T)
29	016E20000	Bush follower
30	-	Nip arm 1 (Not Spared)
31	-	Nip arm 2 (Not Spared)
32	-	Thrust washer (Not Spared)

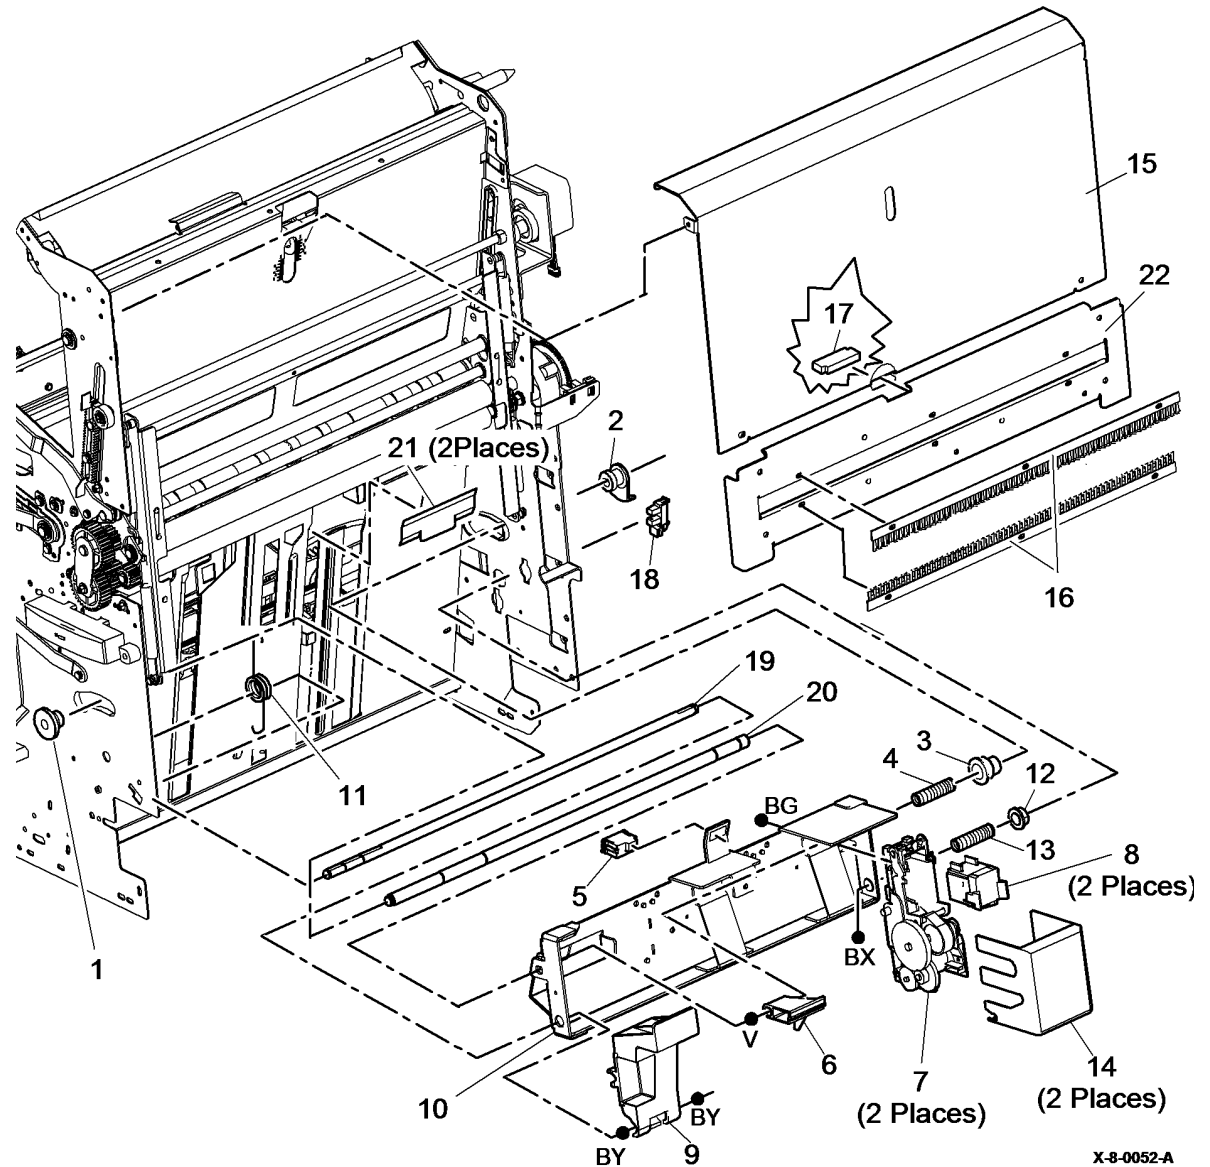
PL 12.185 HVF BM Stapler Assemblies

Item	Part	Description
1	020E38513	Front follower (REP 12.28-171)
2	016E17732	Actuator (REP 12.28-171)
3	-	Rear follower (Not Spared) (REP 12.28-171)
4	809E44010	Spring (REP 12.28-171)
5	130K74090	BM Paper present sensor (Q12-170) (REP 12.28-171)
6	008E06850	Latch slide (REP 12.28-171)
7	029K03233	BM Staple head assembly (REP 12.27-171, ADJ 12.3-171)
8	050K21270	Staple cartridge (1 x 2000)
9	-	Staple bracket handle (Not spared) (REP 12.28-171)
10	-	Stapler bracket assembly (Not Spared) (REP 12.28-171)
11	809E48830	Torsion spring (REP 12.28-171)
12	-	Bearing (Not Spared) (REP 12.28-171)
13	-	Spring (Not Spared) (REP 12.28-171)
14	802E42770	Staple head cover
15	-	BM right cover (Not Spared) (REP 12.56-171)
16	125K03831	Static eliminator
17	130E11640	BM exit sensor (Q12-213) (REP 12.50-171)
18	107E22600	BM Stapler head carrier closed sensor (Q12-217) (REP 12.28-171)
19	-	Lower shaft (Not Spared) (REP 12.28-171)

20	-	Upper shaft (Not Spared) (REP 12.28-171)
21	055E51870	Mylar guide
22	-	Exit plate (Not Spared)

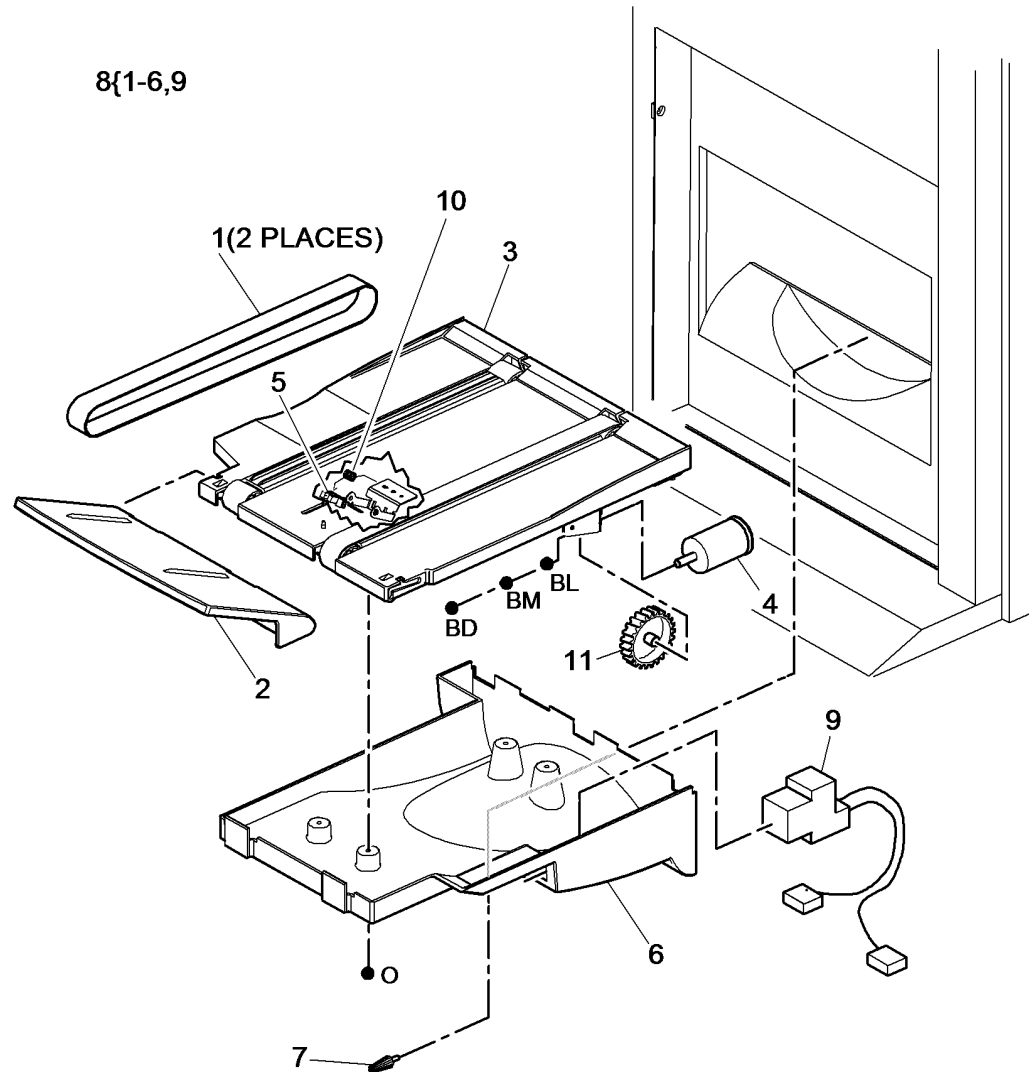
PL 12.190 HVF BM Bin 2

Item	Part	Description
1	023E18612	Conveyor belt (REP 12.29-171)
2	050E21971	HVF BM Bin 2 extension
3	-	HVF BM Bin 2 upper cover (P/O PL 12.190 Item 8)
4	127K53630	BM Conveyor drive motor (MOT12-274)
5	019E61171	HVF BM Bin 2 90% full sensor (Q12-206)
6	-	HVF BM Bin 2 lower cover (P/O PL 12.190 Item 8)
7	826E32840	Thumbscrew
8	050K67740	HVF BM Bin 2 assembly
9	-	HVF BM Bin 2 connector (Not Spared)
10	809E47341	HVF Bin 2 actuator spring
11	007E69000	Gear (50T)/pulley (24T)

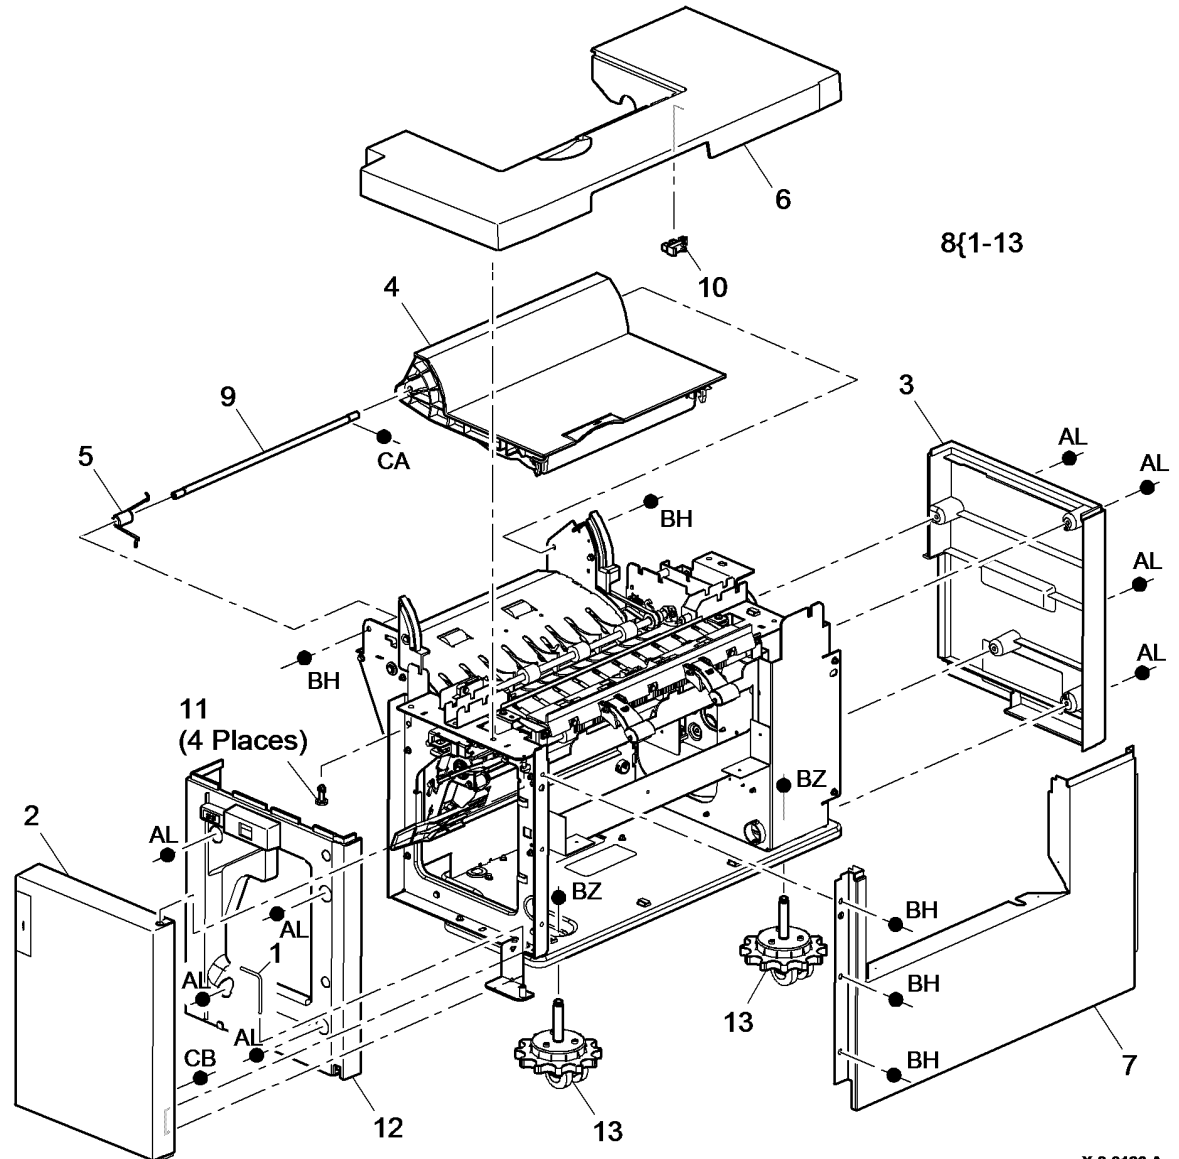
PL 12.200 Tri-Folder Covers

Item	Part	Description
1	–	Door pin (Not spared)
2	802K94010	Front door (REP 12.67-171)
3	848K11741	Rear cover (REP 12.67-171)
4	–	Top cover door assembly (P/O PL 12.200 Item 8) (REP 12.73-171)
5	–	Top cover door assembly spring (P/O PL 12.200 Item 8)
6	802E93931	Top cover
7	848E17430	Right hand side cover (REP 12.67-171)
8	–	Tri-Folder (complete) (Not Spared)
9	–	Top cover door assembly shaft (P/O PL 12.200 Item 8)
10	107E26490	Tri fold top cover interlock sensor (Q12-210) (REP 12.77-171)
11	–	Top cover locking stud (Not Spared)
12	802E99581	Front cover
13	017K04190	Caster

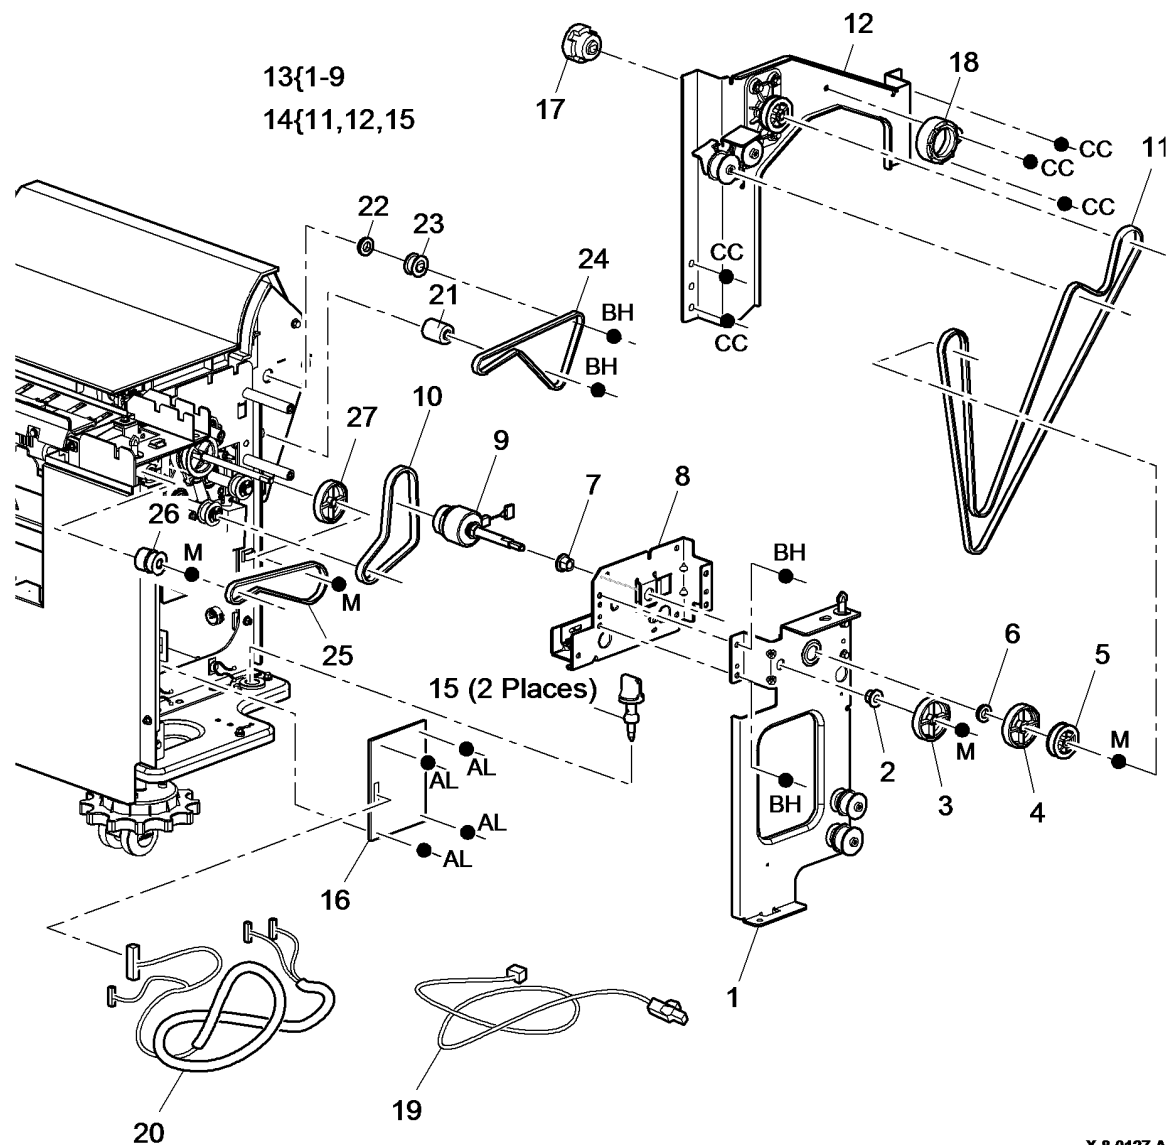
PL 12.205 Tri-Folder Drives Module

Item	Part	Description
1	-	Drive coupling assembly bracket (P/O PL 12.205 Item 13)
2	-	Bearing (P/O PL 12.205 Item 13)
3	-	Feed/exit roll drive gear (40T) (P/O PL 12.205 Item 13)
4	-	Gear (40T) (Black) (P/O PL 12.205 Item 13)
5	-	Driven pulley (P/O PL 12.205 Item 13)
6	-	Bearing (P/O PL 12.205 Item 13)
7	-	Bearing (P/O PL 12.205 Item 13)
8	-	Idler assembly bracket (P/O PL 12.205 Item 13)
9	-	Drive clutch (CL12-269) (P/O PL 12.205 Item 13)
10	-	Crease roll belt (Not Spared)
11	023E30780	Coupler drive belt (REP 12.68-171)
12	007K14460	Install kit drive assembly
13	005K12690	Drive coupling assembly (REP 12.69-171)
14	675K53640	Tri-Folder install kit (REP 12.68-171)
15	-	Thumb screw (P/O PL 12.205 Item 14)
16	960K24000	Tri-folder PWB (REP 12.80-171)
17	-	Drive coupler (Not Spared)
18	-	Align gauge coupler (Not Spared)
19	962K49592	Bin 2 tray harness (REP 12.81-171)
20	962K49571	Bookletmaker PWB to Tri-folder PWB harness (PJ602)

21	-	Drive belt tensioner pulley (Not Spared)
22	-	Feed roller bearing (Not Spared)
23	-	Feed roll pulley (Not Spared) (REP 12.70-171)
24	-	Feed roll belt (Not Spared) (REP 12.70-171)
25	023E23370	Feed roll drive belt
26	020E39921	Pulley gear (19T/20T) (BM)
27	020E39930	Pulley (38T)

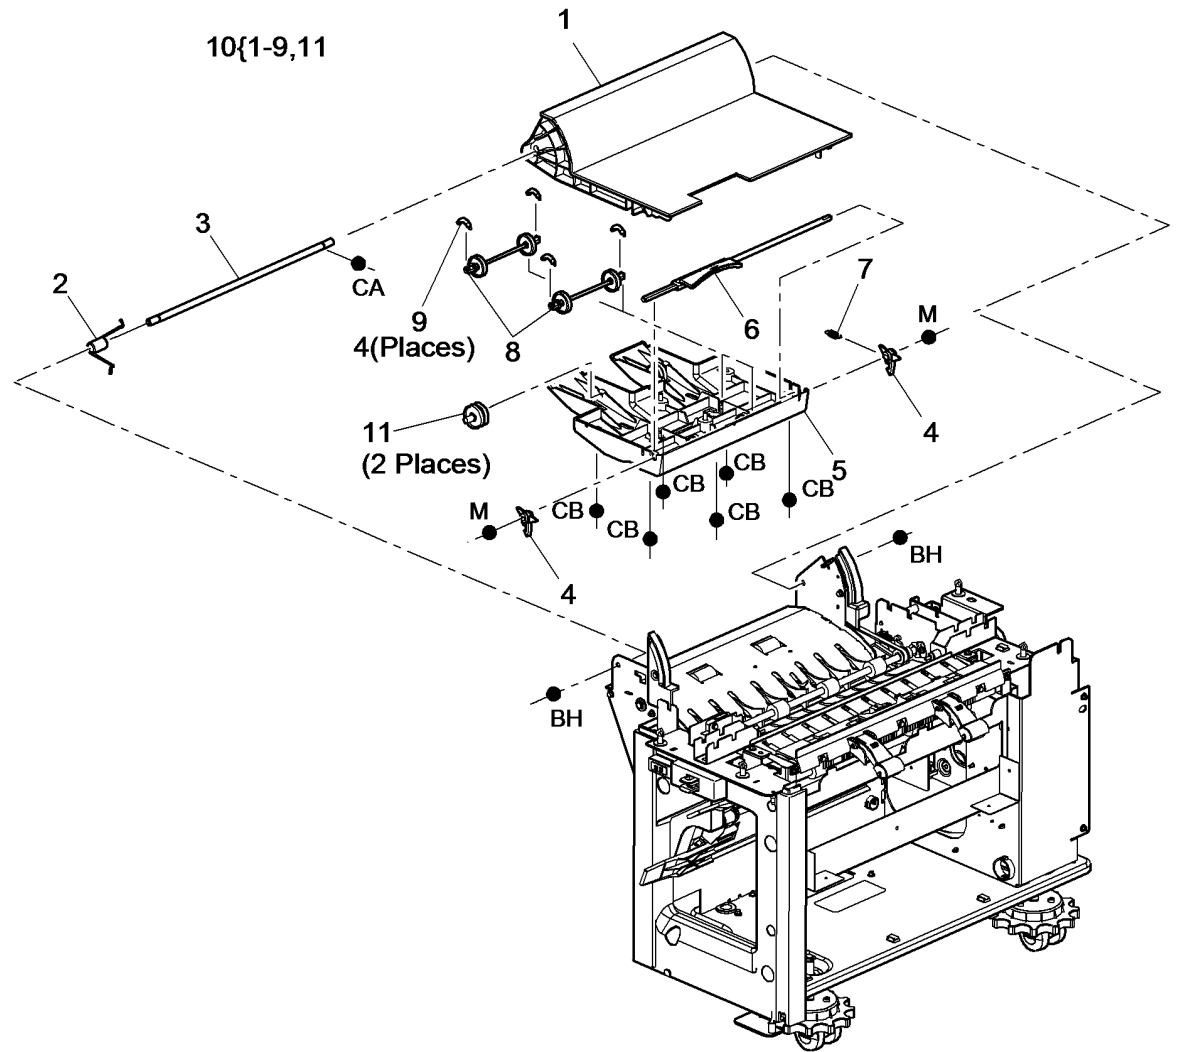
PL 12.210 Tri-Folder Top Door Cover Assembly

Item	Part	Description
1	-	Top access cover (P/O PL 12.210 Item 10)
2	-	Top cover door assembly spring (P/O PL 12.210 Item 10)
3	-	Top cover door assembly shaft (P/O PL 12.210 Item 10)
4	-	Latch hook (P/O PL 12.210 Item 10)
5	-	Top door cover assembly base (P/O PL 12.210 Item 10)
6	-	Latch handle (P/O PL 12.210 Item 10)
7	-	Latch spring (P/O PL 12.210 Item 10)
8	059K58690	Idler assembly (REP 12.73-171)
9	-	Idler spring (P/O PL 12.210 Item 10)
10	848K11680	Top cover door assembly (REP 12.73-171)
11	-	Idler assembly (P/O PL 12.210 Item 10)

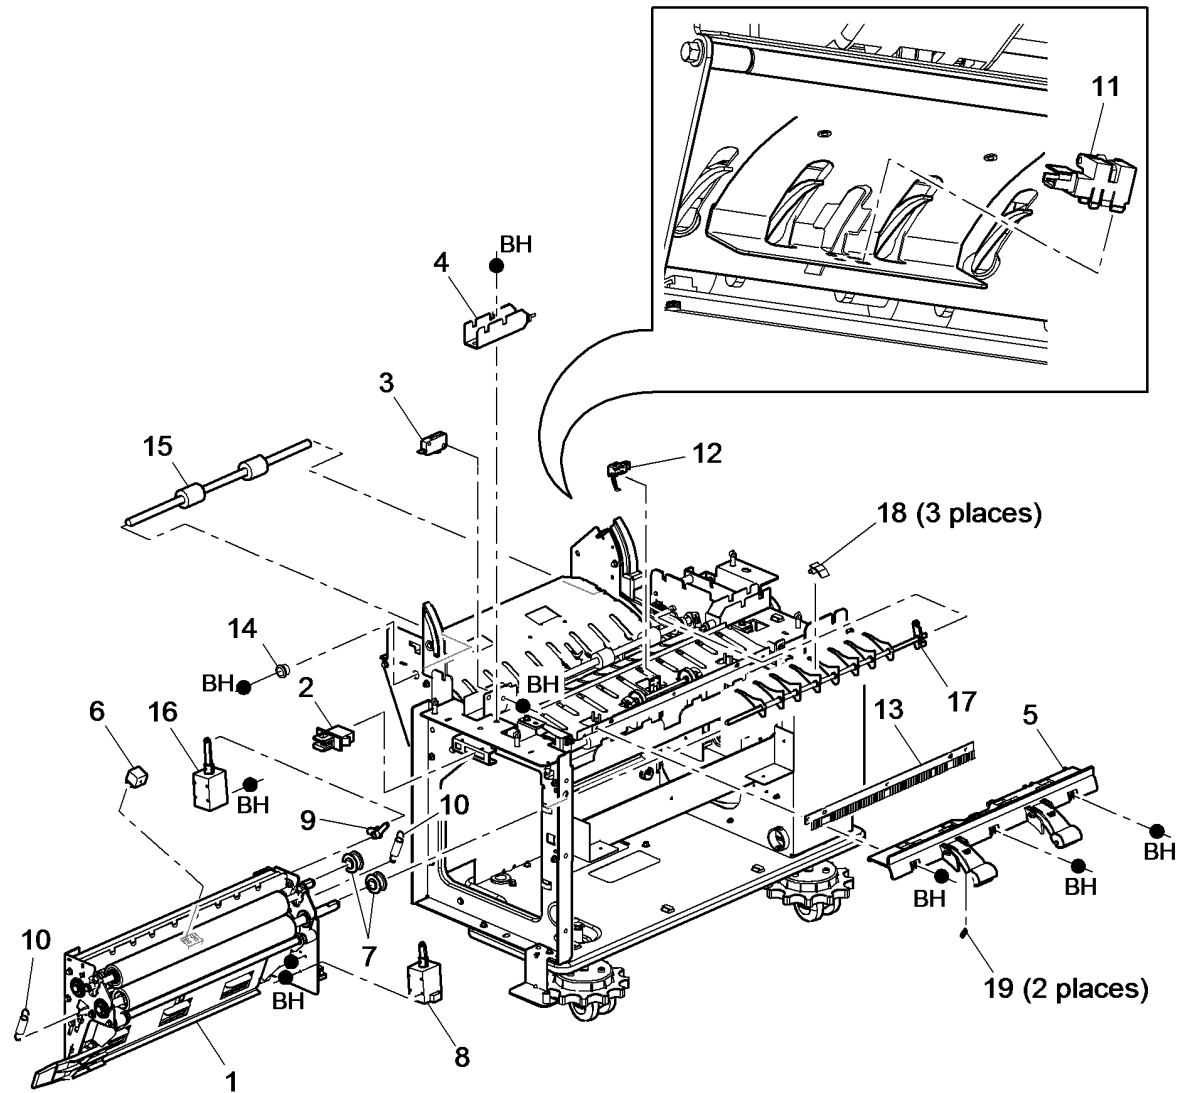
PL 12.215 Tri-Folder Main Drives Assembly

Item	Part	Description
1	-	Roller assembly (Not Spared) (REP 12.74-171)
2	110E19840	Front door interlock switch (S12-209) (REP 12.77-171)
3	110E19831	Top cover interlock switch (S 12-210) (REP 12.77-171)
4	-	Top access cover docking catch (Not Spared)
5	-	Pressing and stacking assembly (Not Spared)
6	130E11861	Assist gate sensor (Q12-165) (REP 12.78-171)
7	020E38480	Centerfold pulley (REP 12.74-171)
8	121K44660	Assist gate solenoid (SOL12-268) (REP 12.71-171)
9	011E13832	Centerfold entry gate lever (REP 12.74-171)
10	809E44040	Crease roll spring (REP 12.72-171)
11	130K74920	Tri folder entry sensor (Q12-164) (REP 12.78-171)
12	130K74051	Tri folder exit sensor (Q12-166) (REP 12.79-171)
13	-	Static eliminator (Not Spared)
14	-	Feed roller bearing (Not spared)
15	-	Feed roller (Not Spared) (REP 12.70-171)
16	121K44650	Tri folder diverter solenoid (SOL12-267) (REP 12.74-171)
17	050E23180	Diverter gate
18	050E28950	Diverter gate spring clip

19	809E95080	Nip spring
