708P91368
September 2017

Xerox® AltaLink® B8090 Family Multifunction Printer Service Manual

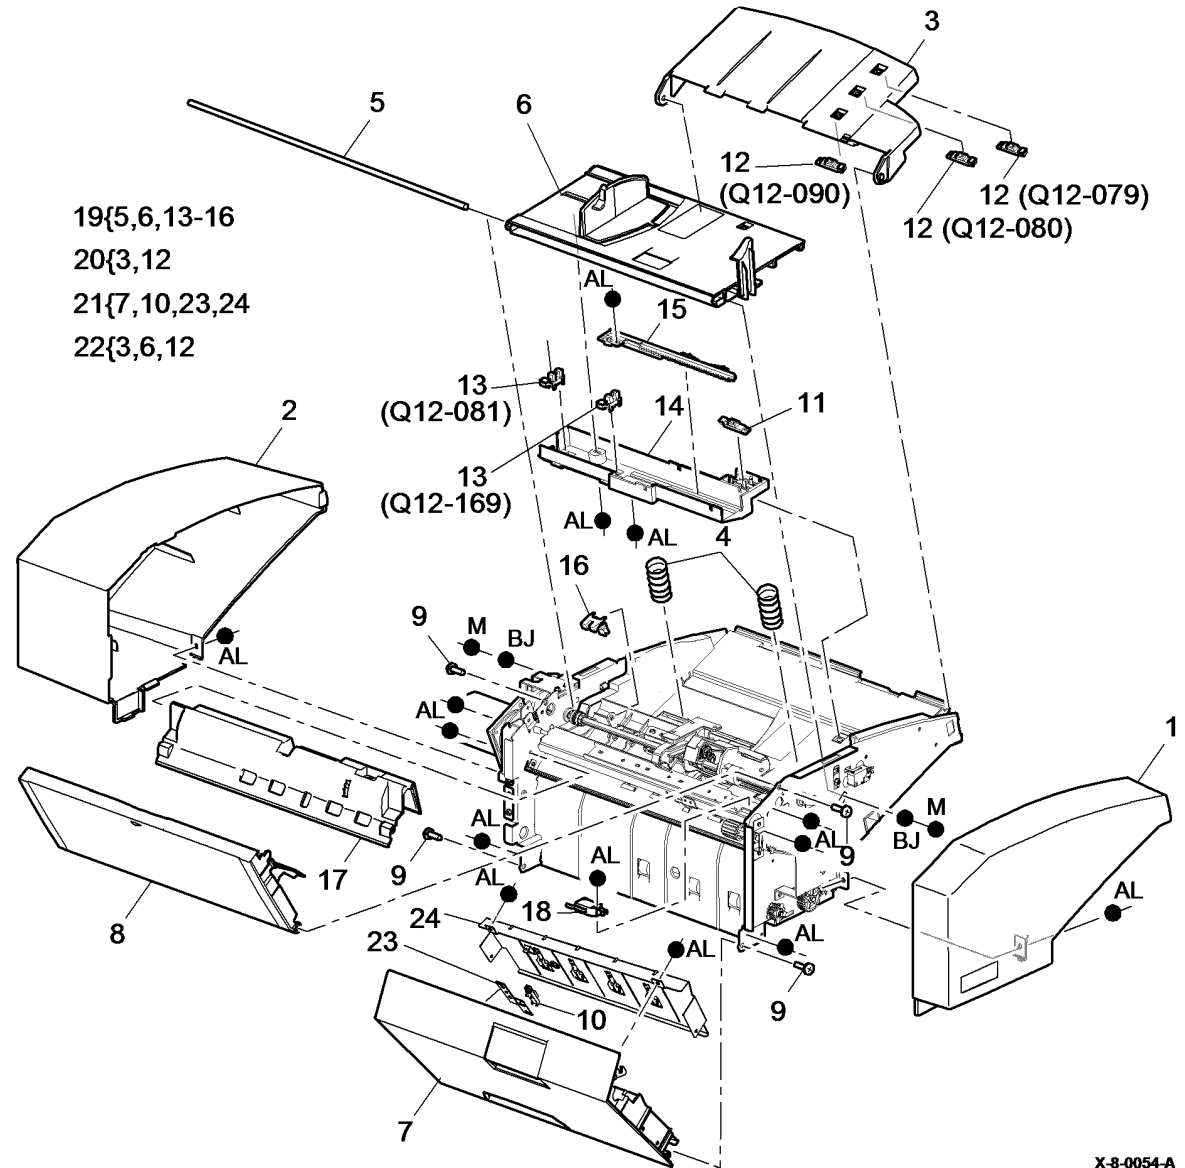
PL 12.300 Inserter Covers

Item	Part	Description
1	-	Front cover (Not Spared) (REP 12.83-171)
2	-	Rear cover (Not Spared) (REP 12.83-171)
3	-	Sensor tray (P/O PL 12.300 Item 20) (REP 12.89-171)
4	-	Bottom tray spring (Not Spared)
5	-	Bottom tray shaft (Not Spared)
6	-	Bottom tray (P/O PL 12.300 Item 19) (REP 12.90-171)
7	-	Lower jam cover (P/O PL 12.300 Item 21) (REP 12.92-171)
8	-	Top cover door (REF: PL 12.310 Item 17)
9	-	Pivot pin (Not spared)
10	-	Inserter acceleration sensor (Q12-316) (P/O PL 12.300 Item 21) (REP 12.92-171)
11	-	Inserter unit empty sensor (Q12-082) (Not spared) (REP 12.90-171)
12	-	Inserter paper length 1 sensor (Q12-079)/Inserter paper length 2 sensor (Q12-080), Inserter paper length sensor 3 (Q12-090) (Not Spared) (REP 12.89-171)
13	-	Paper width sensor 1 (Q12-081), Paper width sensor 2 (Q12-169) (P/O PL 12.300 Item 19) (REP 12.90-171)
14	-	Bottom tray bracket (P/O PL 12.300 Item 19)
15	-	Bottom tray rack (P/O PL 12.300 Item 19)

16	-	Inserter bottom plate sensor (Q12-085) (P/O PL 12.300 Item 19) (REP 12.94-171)
17	-	Top inside cover (Not Spared)
18	-	Inserter jam cover interlock switch (S12-179) (Not Spared) (REP 12.88-171)
19	050K68510	Bottom tray assembly
20	848K31350	Sensor tray assembly
21	-	Lower jam cover assembly (Not Spared)
22	848K31370	Main tray assembly
23	-	Bracket (P/O PL 12.300 Item 21)
24	-	Lower jam inner cover (P/O PL 12.300 Item 21)

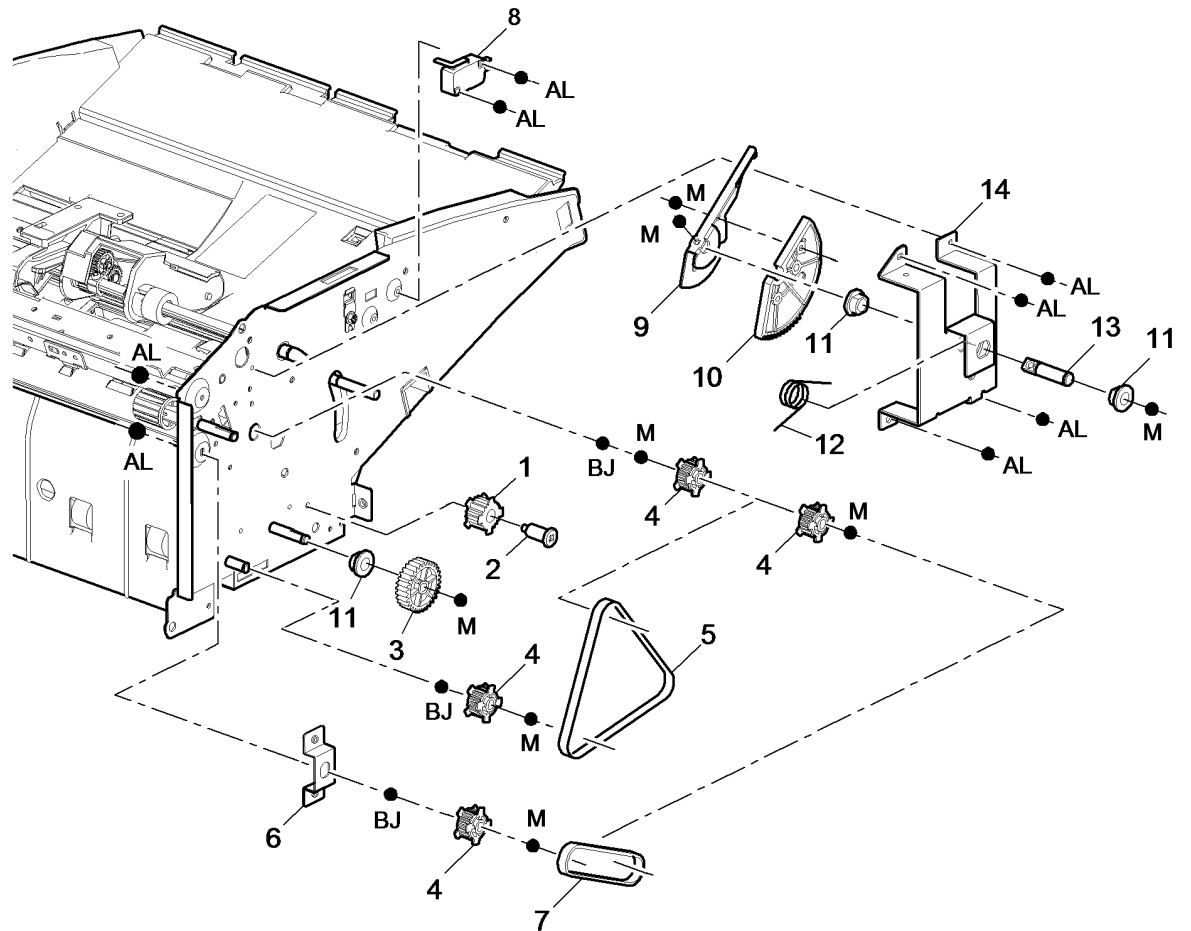
PL 12.305 Inserter Main Drives (1 of 3)

Item	Part	Description
1	–	Idler (Not Spared)
2	–	Idler pin (Not Spared)
3	–	Gear (Not Spared)
4	–	Pulley (Not Spared)
5	–	Belt (Not Spared)
6	–	Bracket (Not Spared)
7	–	Jam drive belt (Not Spared)
8	–	Inserter top cover interlock switch (S12-178) (Not Spared) (REP 12.87-171)
9	–	Loading lever (Not Spared)
10	–	Loading gear (Not Spared)
11	–	Bearing (Not Spared)
12	–	Torsion spring (Not Spared)
13	–	Loading shaft (Not Spared)
14	–	Front loading bracket (Not Spared)

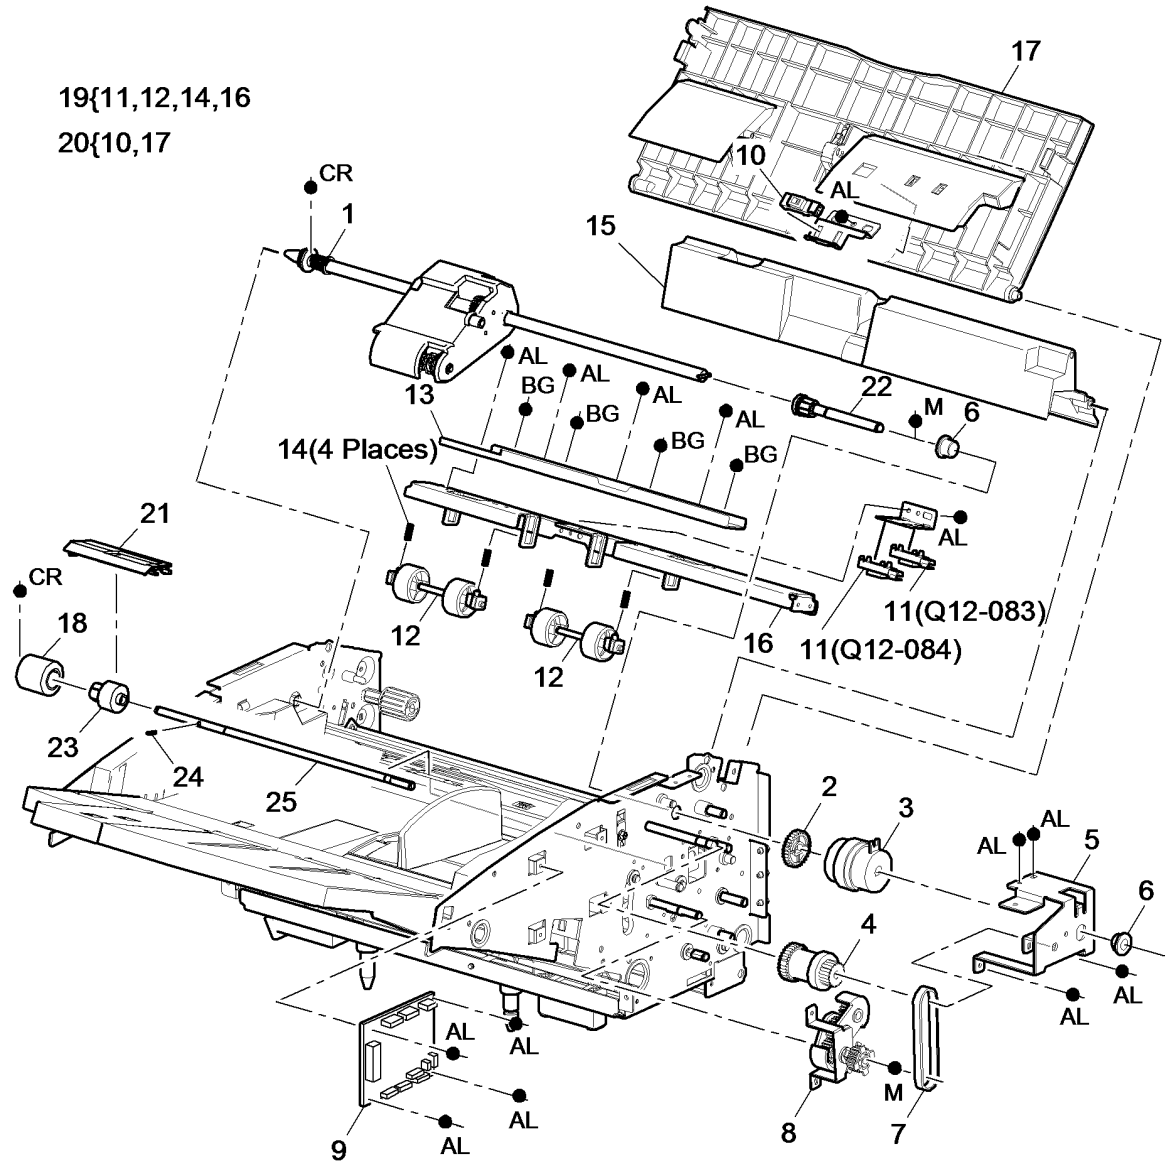
PL 12.310 Inserter Main Drives (2 of 3)

20	848K31360	Top cover door assembly
21	848K37330	Retard cover
22	-	Drive coupling (Not Spared)
23	-	Reverse feed roll core (Not Spared)
24	-	Pin (Not Spared)
25	-	Shaft (Not Spared)

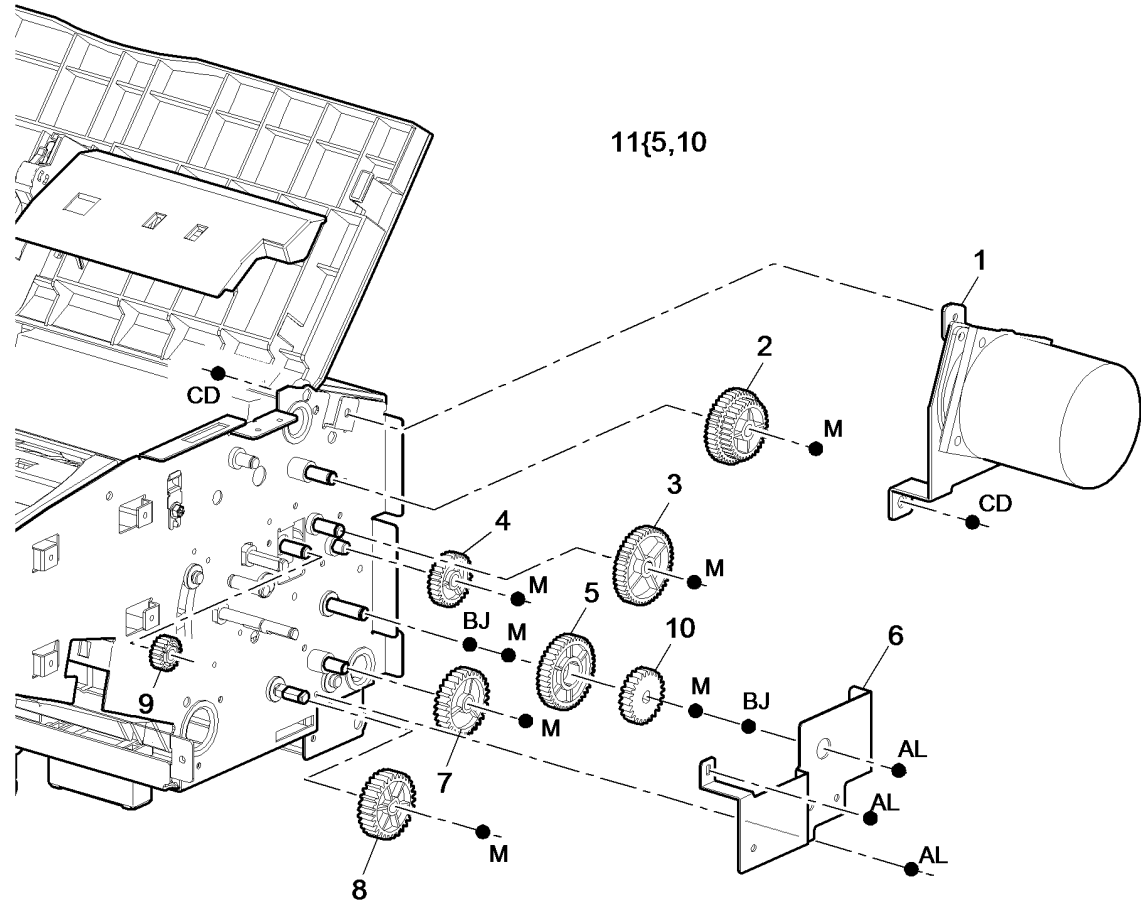
PL 12.315 Inserter Main Drives (3 of 3)

Item	Part	Description
1	127K61990	Inserter motor (MOT12-261) (REP 12.84-171)
2	-	Idler (Not Spared)
3	-	Driver gear (Not Spared)
4	-	Idler (Not Spared)
5	-	Tray down gear (Not Spared)
6	-	Gear cover bracket (Not Spared)
7	-	Idler (Not Spared)
8	-	Bottom shaft drive (Not Spared)
9	-	Feed roller drive gear (Not Spared)
10	-	Tray down clutch (Not Spared)
11	-	Tray down clutch assembly (Not Spared)

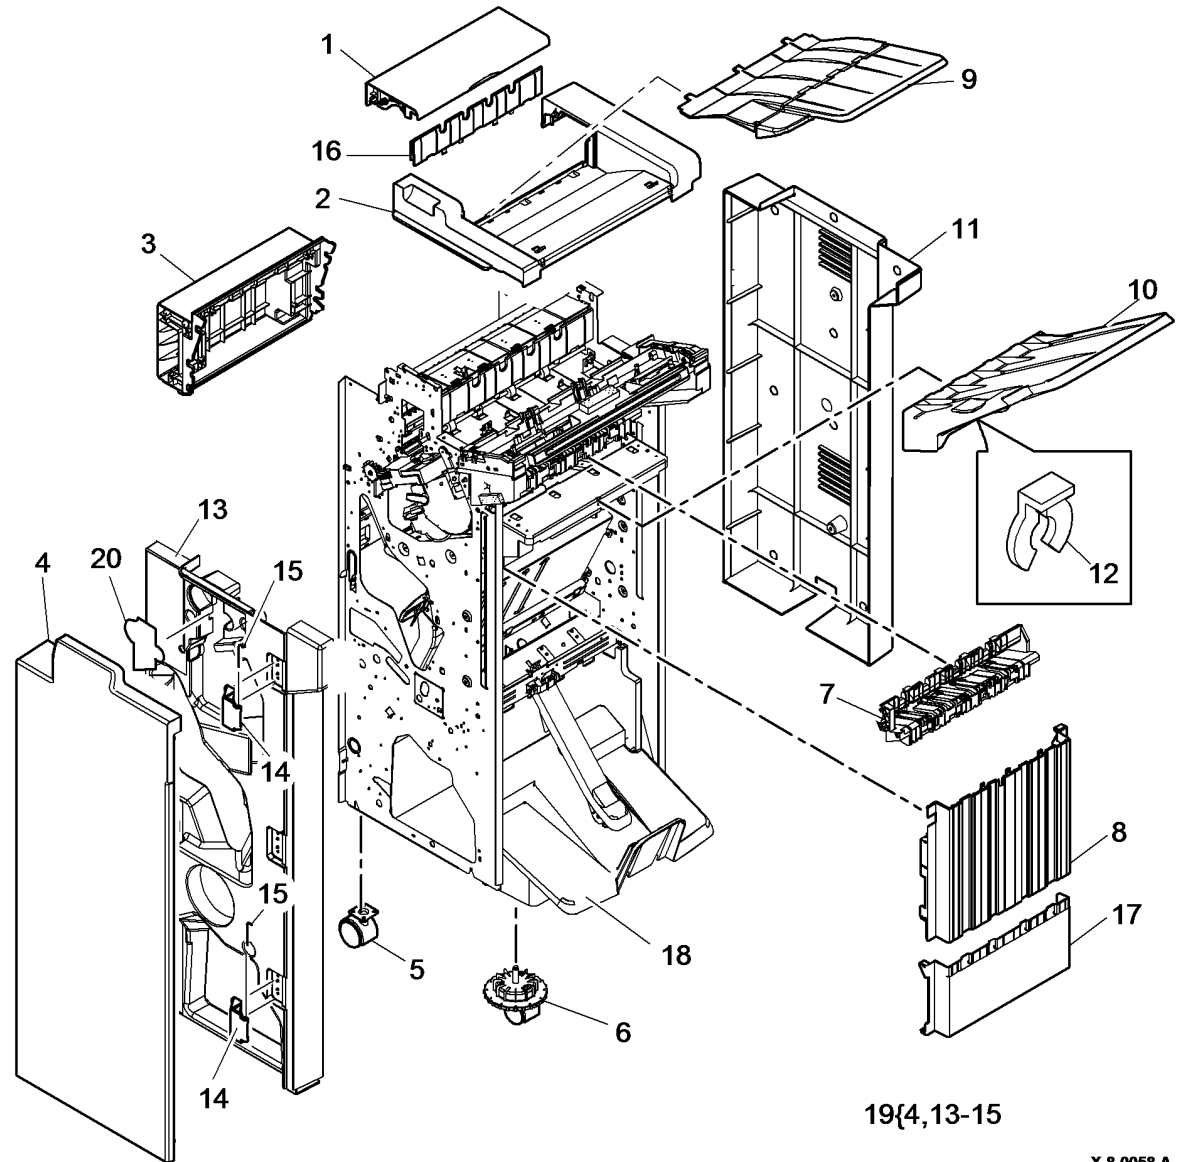
PL 12.320 LVF BM - Covers

Item	Part	Description
1	948K25970	Exit cover
2	822E52611	Top cover (REP 12.1-150)
3	848K83730	Entry guide cover assembly (REP 12.15-150)
4	–	Front door (P/O PL 12.320 Item 19) (REP 12.1-150)
5	017K03750	Fixed castor
6	017K04520	Adjustable castor
7	–	Output cover (Not Spared)
8	–	Right cover (Not Spared)
9	050K75970	Bin 0
10	050K75960	Bin 1 (ADJ 12.1-150)
11	948K25841	Rear cover (REP 12.1-150)
12	019K13380	Bin 1 alignment clip
13	–	Front cover assembly (P/O PL 12.320 Item 19)
14	–	Hinge (P/O PL 12.320 Item 19)
15	–	Hinge pin (P/O PL 12.320 Item 19)
16	848E97200	Top centre cover
17	–	Lower right cover (REP 12.45-150)
18	–	Bin 2 (Not Spared)
19	948K22211	Front door cover assembly (REP 12.1-150)
20	–	Hole punch assembly cover (Not Spared)

NOTE: Refer to ADJ 12.2-150 to align the LVF BM to the machine.

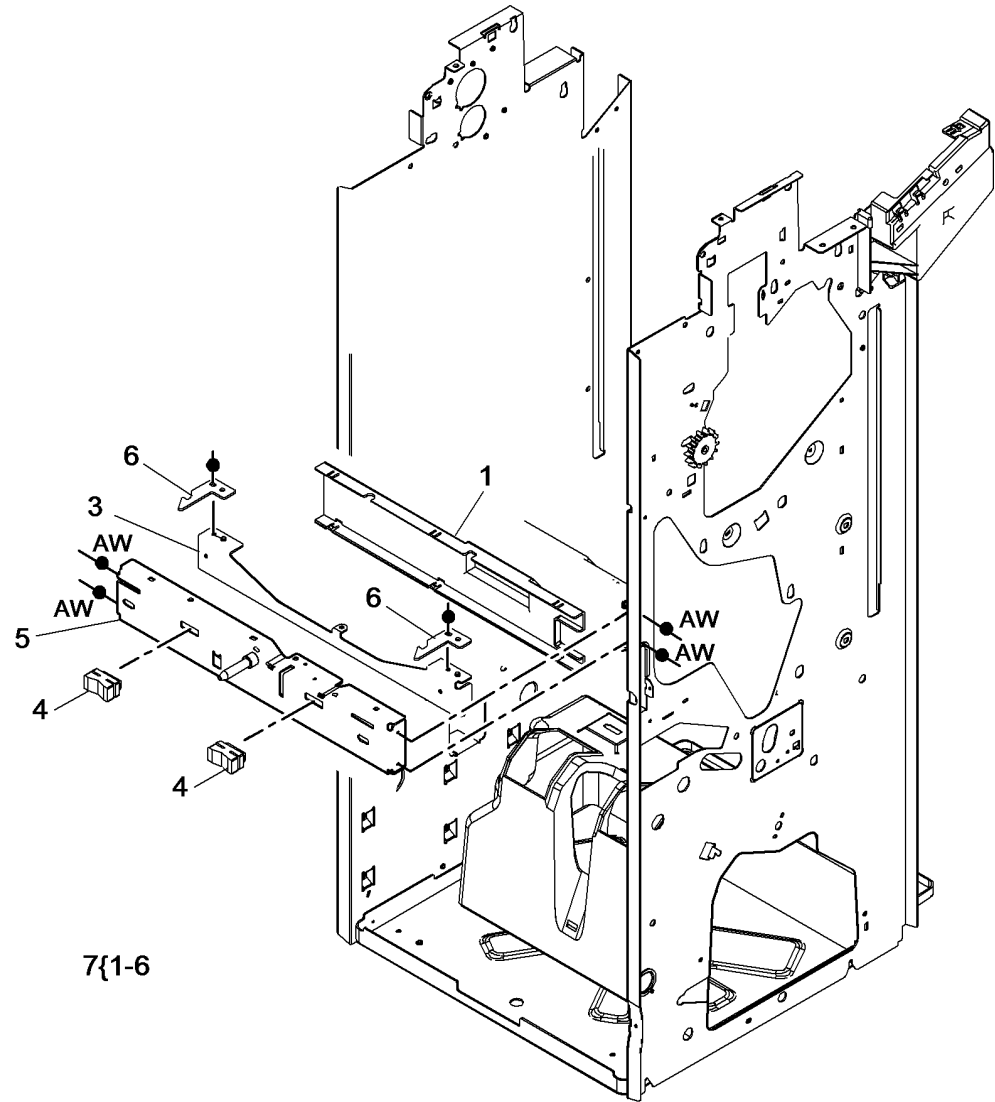
PL 12.325 LVF BM Docking Latch

Item	Part	Description
1	–	Docking latch cover (Not Spared)
2	–	Not used
3	–	Link bracket assembly (P/O PL 12.325 Item 7)
4	–	Stopper (P/O PL 12.325 Item 7)
5	–	Docking latch (P/O PL 12.325 Item 7)
6	–	Latch hook (P/O PL 12.325 Item 7)
7	017K06290	Docking latch assembly (REP 12.16-150)

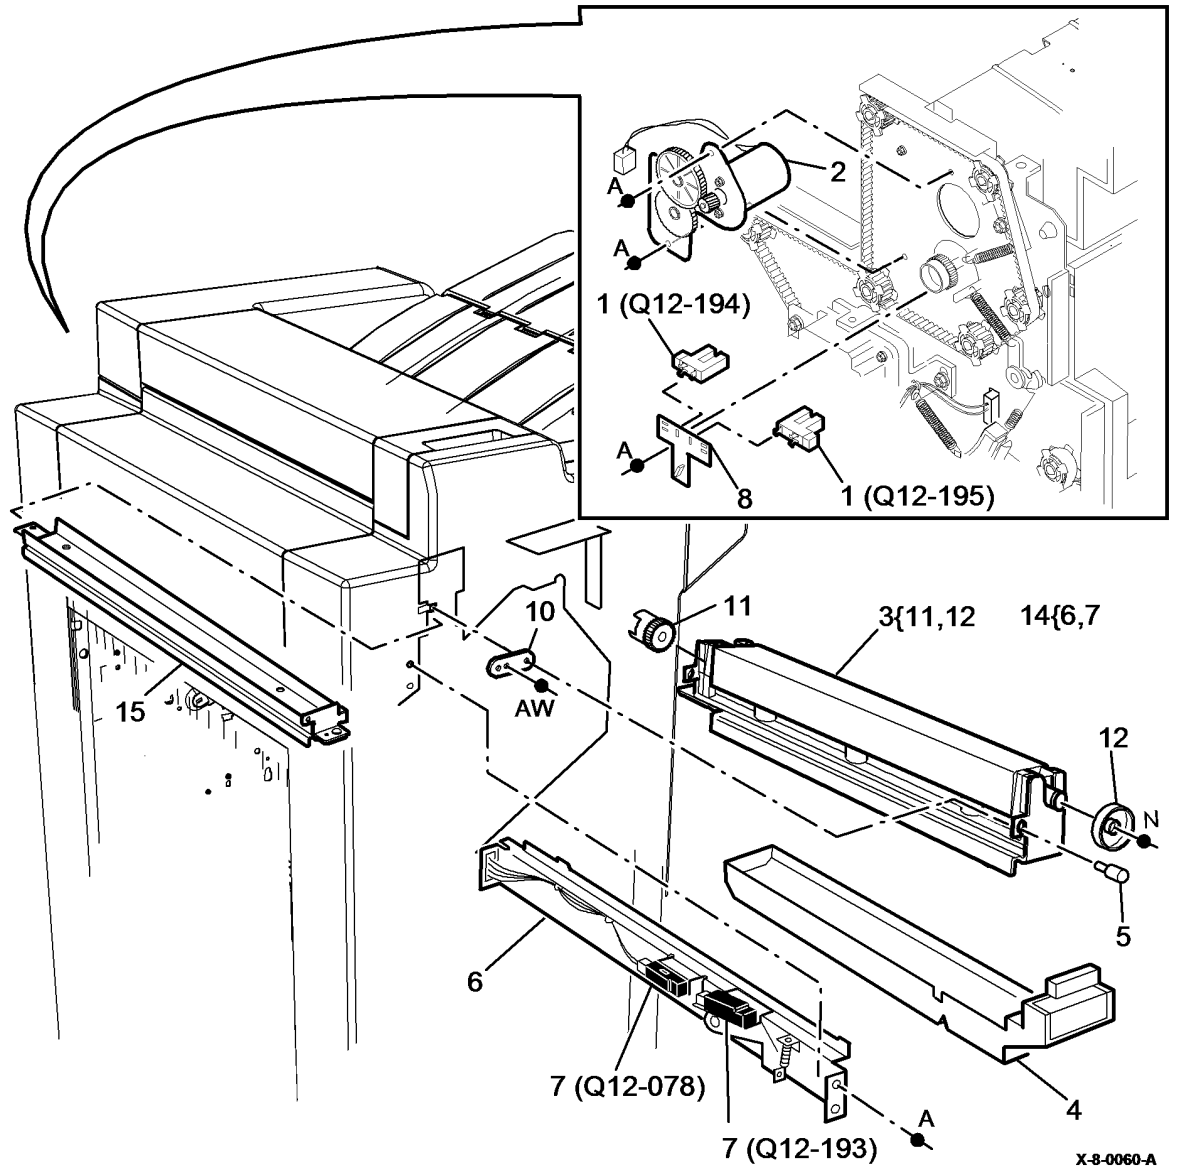
PL 12.330 LVF BM Hole Punch Unit

Item	Part	Description
1	130E10360	Punch head home sensor (Q12-194), Punch head present sensor (Q12-195) (REP 12.7-150)
2	127K55900	Punch head motor assembly (MOT12-243) (REP 12.7-150)
3	-	Hole punch unit (see below for variants) (REP 12.7-150)
-	180K01540	2 Hole (P/O PL 31.11 Item 2) (XE)
-	-	2 Hole legal (P/O PL 31.11 Item 2)
-	180K01570	3 Hole (USSG/XCL)
-	-	4 Hole (Sweden) (P/O PL 31.11 Item 2)
-	-	4 Hole (P/O PL 31.11 Item 2) (XE)
4	093E03930	Chad bin
5	-	Thumb screw (Not Spared)
6	-	Bracket (P/O PL 12.330 Item 14)
7	130E10380	Punch sensor 1 (Q12-078), Chad bin level sensor (Q12-193) (REP 12.7-150)
8	-	Sensor bracket (Not Spared)
9	-	Not used
10	-	Bracket (Not Spared)
11	-	Punch drive gear (P/O PL 12.330 Item 9)
12	-	Punch cam (P/O PL 12.330 Item 3)
13	-	Not used
14	-	Punch sensor assembly (Not Spared)
15	014K10610	Hole punch guide assembly

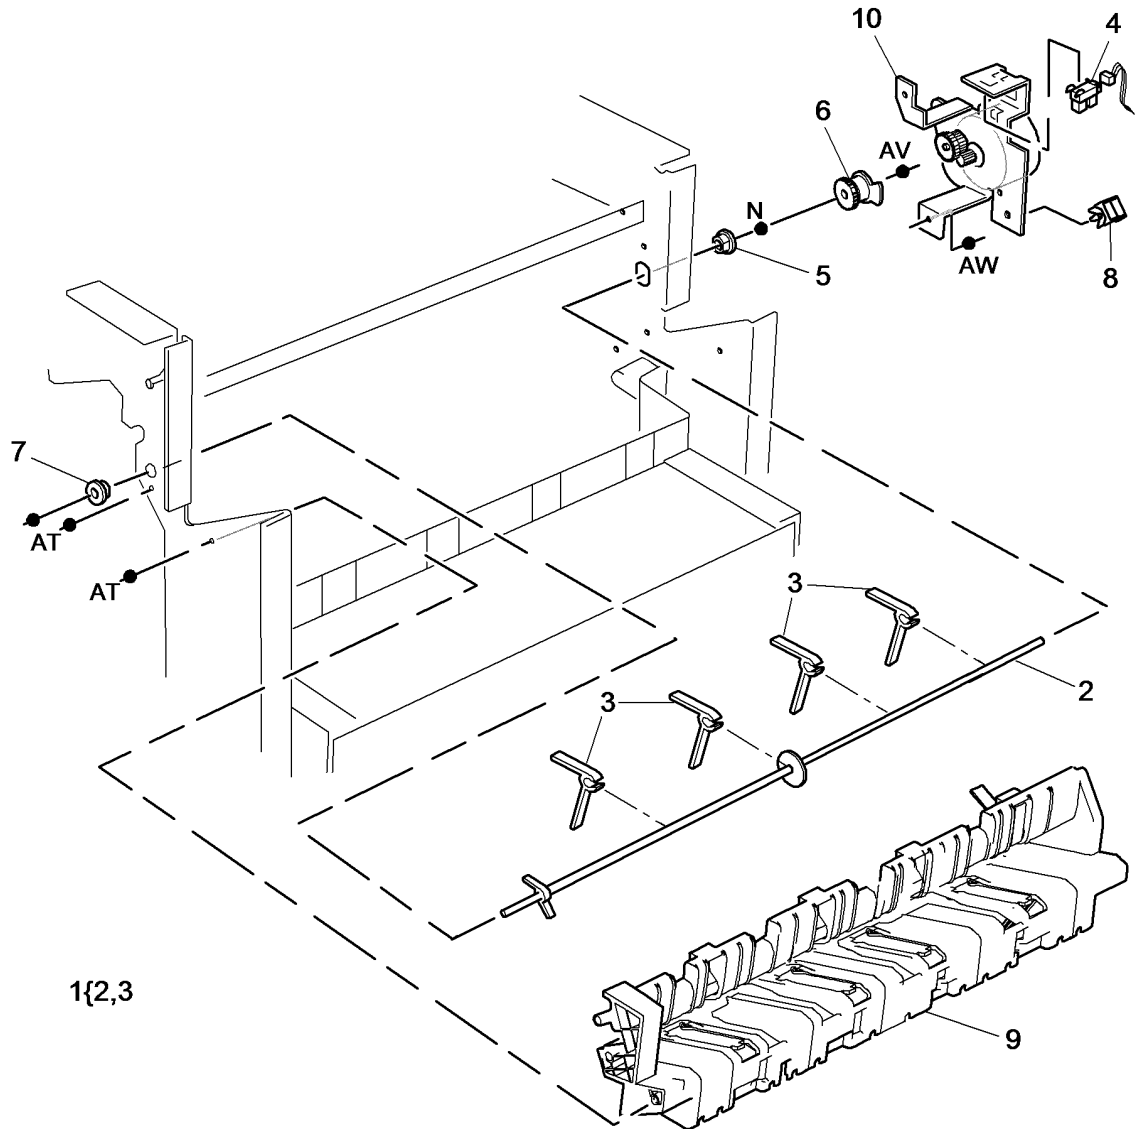
PL 12.335 LVF BM Paddle Shaft Assembly

Item	Part	Description
1	-	Paddle shaft assembly (REF: PL 31.12 Item 2) (REP 12.12-150)
2	-	Shaft (P/O PL 12.335 Item 1)
3	-	Paddle (P/O PL 12.335 Item 1) (See NOTE)
4	130E10360	Paddle roll home sensor (Q12-186)
5	013E25790	Nylon bearing
6	-	Gear and flag assembly (Not Spared)
7	-	Bushing (Not Spared)
8	-	Cable clamp (Not Spared)
9	-	Output cover (REF: PL 12.320 Item 7)
10	127K62580	Paddle roll motor assembly (MOT12-238) (REP 12.12-150)

NOTE: Paddles are also supplied (4 off) as a kit PL 31.12 Item 5.

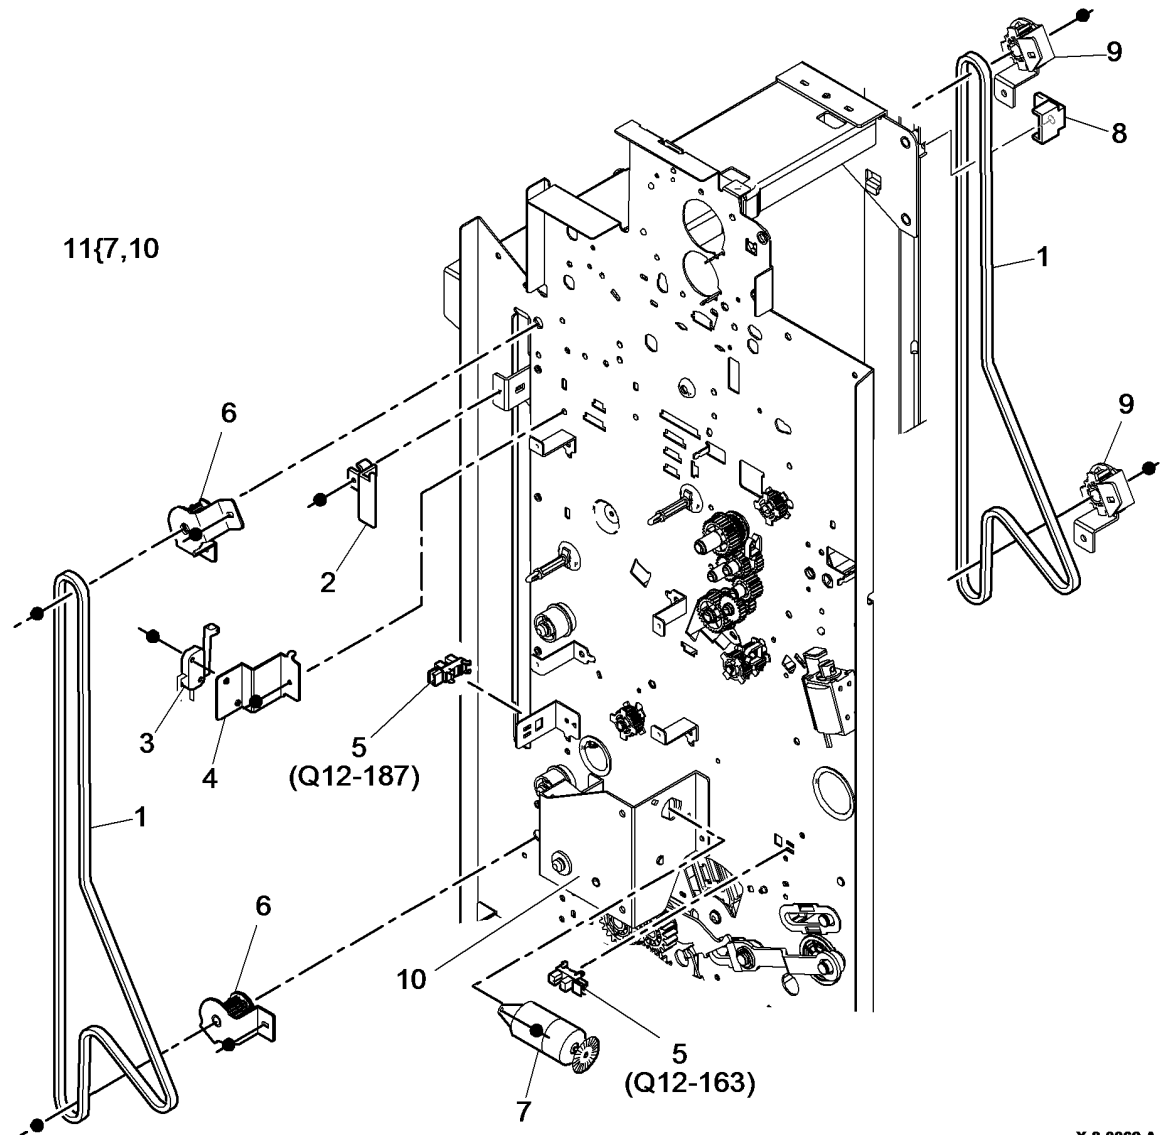
PL 12.340 LVF BM Bin 1 Control Components (1 of 2)

Item	Part	Description
1	023E24320	Bin 1 drive belt (REP 12.5-150)
2	-	Rear belt clamp (Not Spared) (ADJ 12.1-150)
3	110E20180	Bin 1 upper limit switch (S12-190)
4	-	Sensor bracket (Not Spared)
5	130E10360	Bin 1 90% full sensor (Q12-187)/ Bin 1 motor encoder sensor (Q12-163)
6	-	Rear pulley (Not Spared) (ADJ 40.1)
7	127K55891	Bin 1 elevator motor (MOT12-241)
8	-	Front belt clamp (Not Spared) (ADJ 12.1-150)
9	-	Front pulley (Not Spared) (ADJ 40.1)
10	-	Stacker tray drive assembly (P/O PL 12.340 Item 11)
11	007K20531	Stacker tray drive and motor assembly (REP 12.5-150)

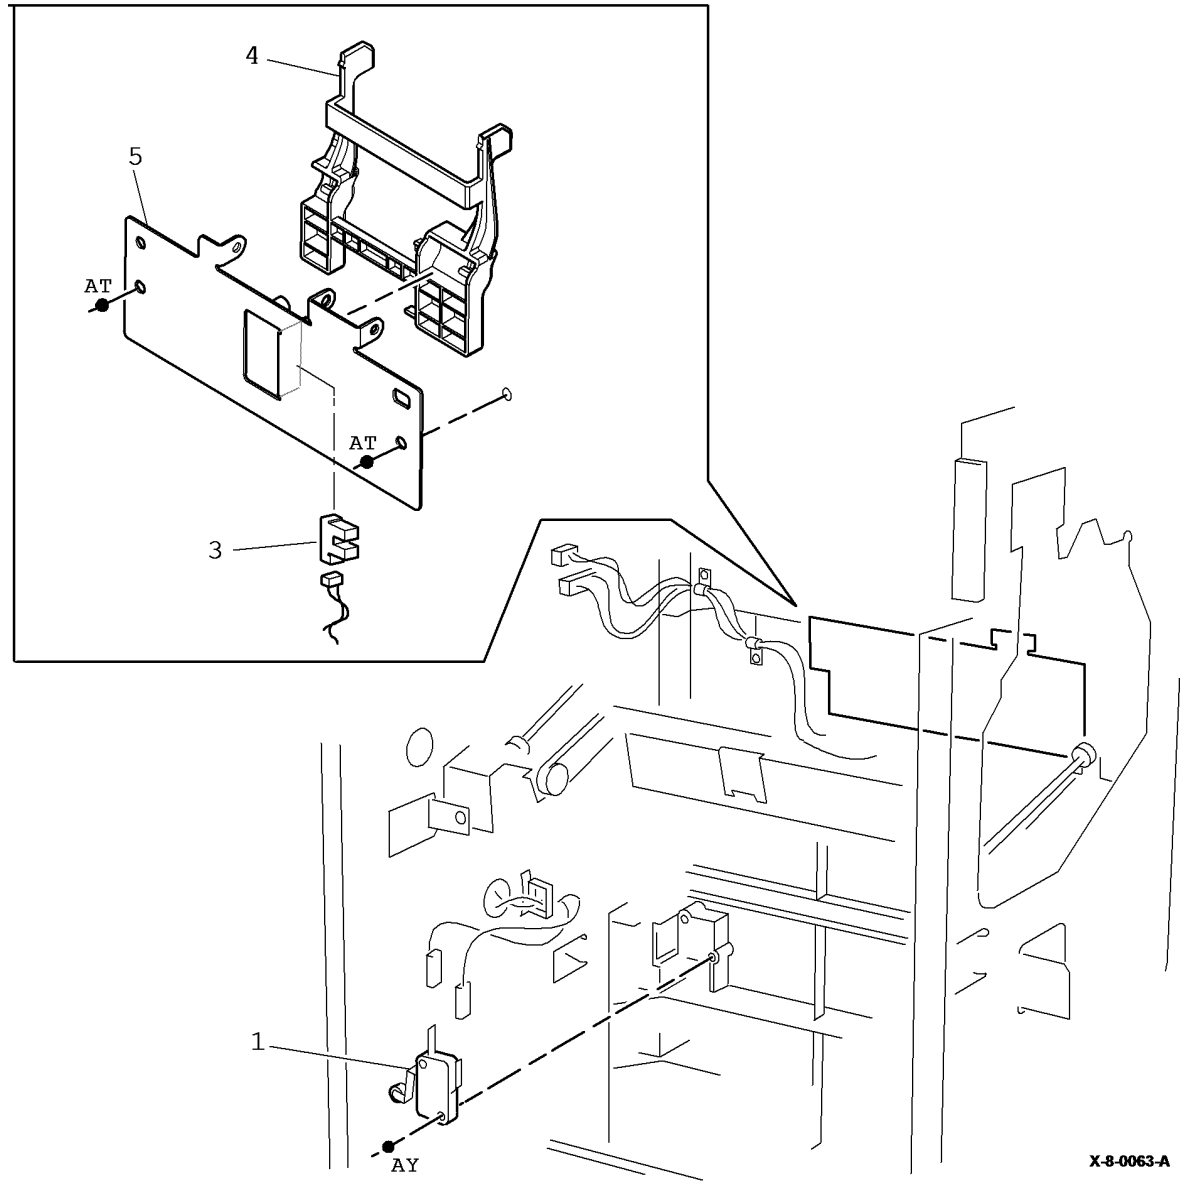
PL 12.345 LVF BM Bin 1 Control Components (2 of 2)

Item	Part	Description
1	110K13990	Bin 1 lower limit switch (S12-191) (REP 12.45-150)
2	-	Not used
3	130E10360	Bin 1 upper level sensor (Q12-188) (REP 12.11-150)
4	-	Actuator (Not Spared)
5	-	Sensor support assembly (Not Spared)

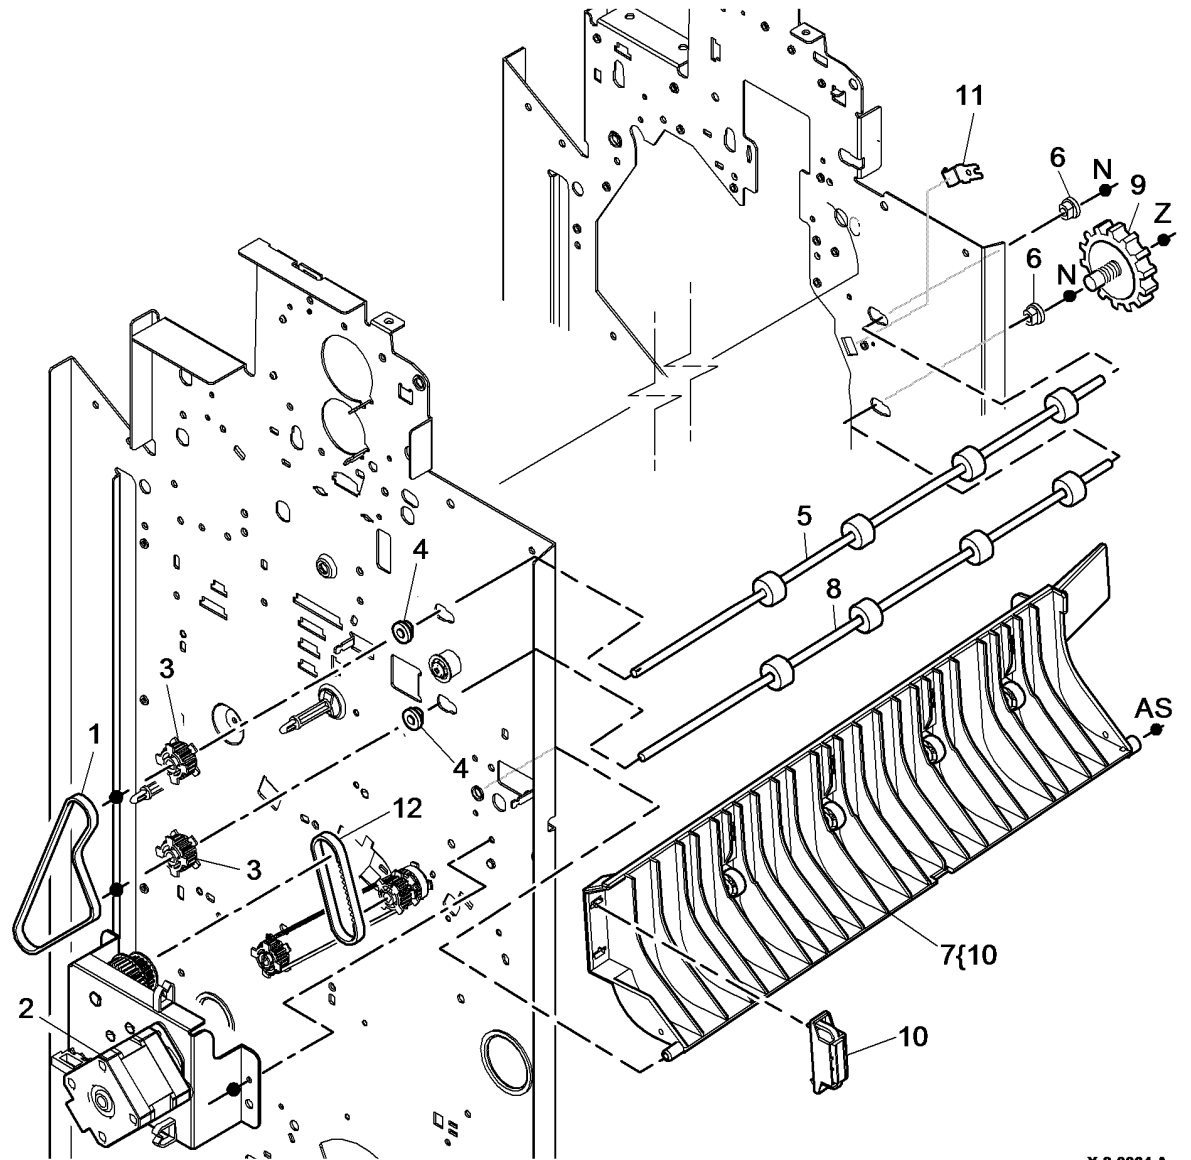
PL 12.350 LVF BM Paper Entry Transport

Item	Part	Description
1	023E24340	Input drive belt (REP 12.2-150)
2	927K01140	Transport motor 1 and gearbox assembly (MOT12-223) (REP 12.3-150)
3	-	Pulley (Not Spared)
4	013E25790	Nylon bearing
5	-	Upper feed roll assembly (Not Spared)
6	013E37460	Bearing
7	-	Paper entry guide assembly (Not Spared)
8	-	Lower feed roll assembly (Not Spared)
9	006K32780	Thumb wheel
10	-	Magnet (P/O PL 12.350 Item 7)
11	-	Latch (Not Spared)
12	-	Compiler entrance drive belt 1 (Not Spared) (REP 12.34-150)

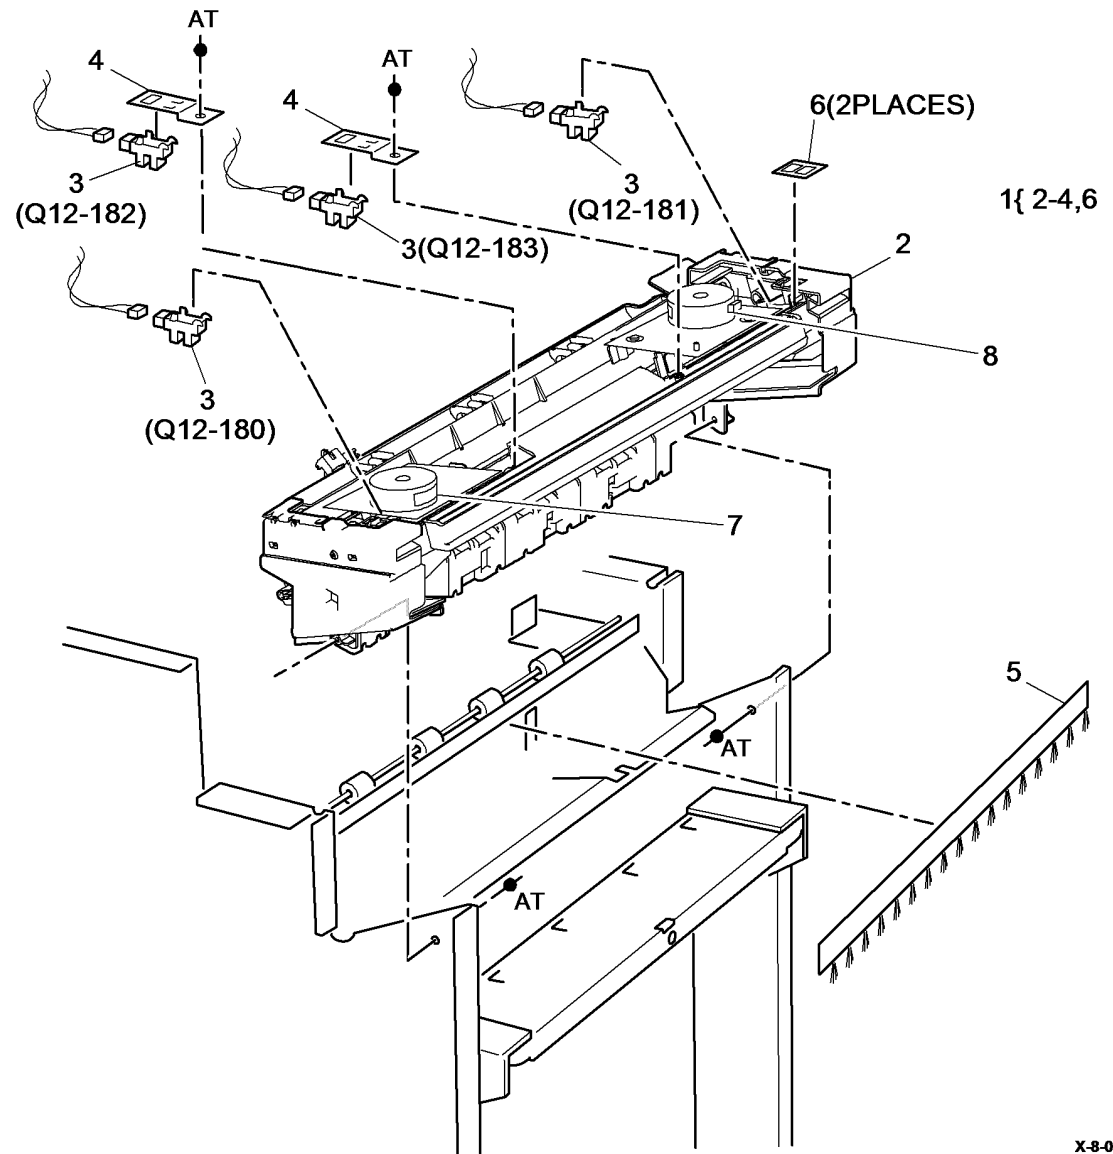
PL 12.355 LVF BM Tamper Assembly

Item	Part	Description
1	049K50680	Tamper assembly (REP 12.6-150)
2	-	Tamper unit (P/O PL 12.355 Item 1)
3	130E10360	Front tamper home sensor (Q12-180), Front tamper away sensor (Q12-182), Rear tamper home sensor (Q12-181), Rear tamper away sensor (Q12-183) (REP 12.6-150)
4	-	Sensor bracket (P/O PL 12.355 Item 1)
5	-	Static eliminator (stacker) (Not Spared)
6	-	Sensor retainer (Not Spared)
7	-	Front tamper motor (MOT12-226) (P/O PL 12.355 Item 1)
8	-	Rear tamper motor (MOT12-227) (P/O PL 12.355 Item 1)
9	869E55190	Tamper arm (Not shown)

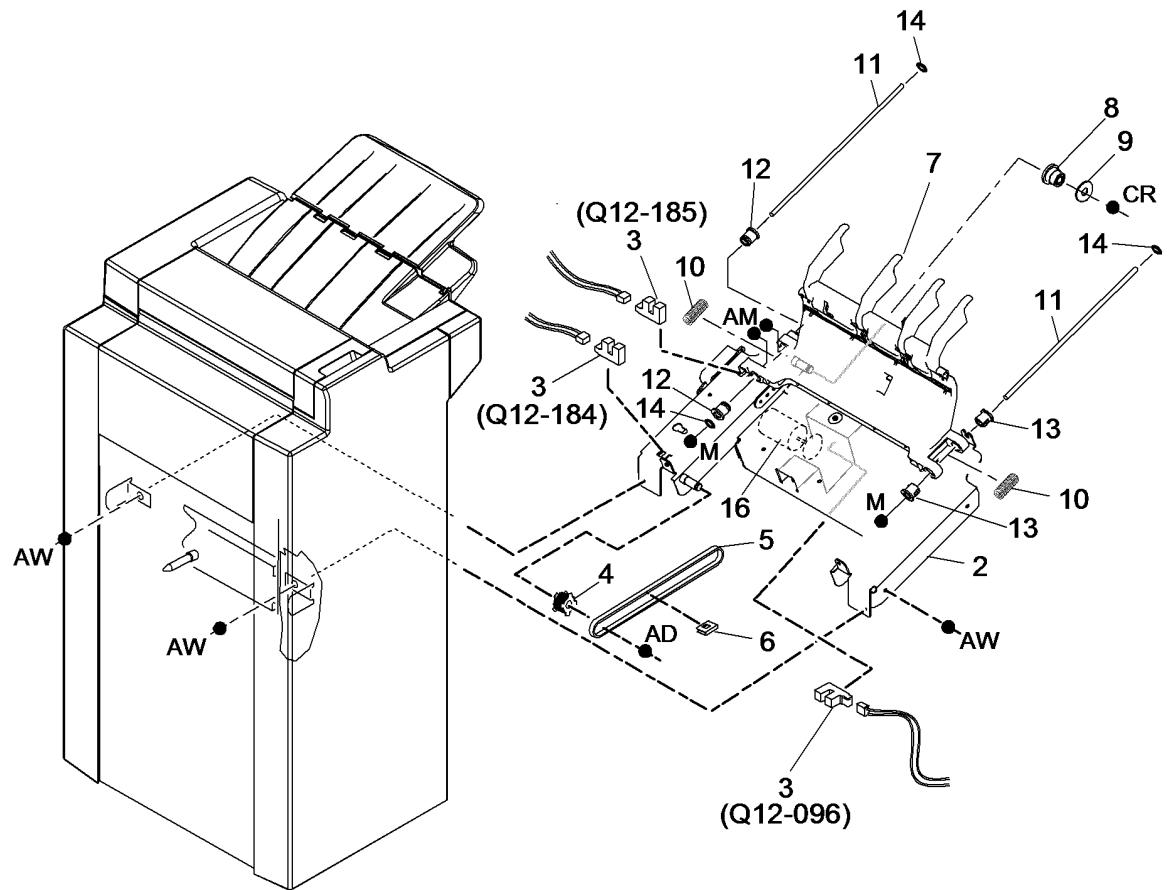
PL 12.360 LVF BM Ejector Assembly

Item	Part	Description
1	054K54273	Ejector assembly (REP 12.10-150)
2	-	Ejector base (P/O PL 12.360 Item 1)
3	130E10360	Ejector home sensor (Q12-184), Ejector out sensor (Q12-185), Ejector motor encoder sensor (Q12-096) (REP 12.10-150)
4	-	Pulley (P/O PL 12.360 Item 1)
5	023E24330	Ejector belt (REP 12.17-150)
6	-	Clip (P/O PL 12.360 Item 1)
7	019K13390	Support finger (REP 12.10-150)
8	020K21490	Pulley drive gear
9	-	Washer (Not Spared)
10	-	Spring (P/O PL 12.360 Item 1)
11	-	Shaft (P/O PL 12.360 Item 1)
12	-	Slide ejector bearing (P/O PL 12.360 Item 15)
13	-	Wide slide ejector bearing (P/O PL 12.360 Item 15)
14	-	Cushion washer (P/O PL 12.360 Item 15)
15	604K67690	Bearing assembly kit
16	-	Ejector motor (MOT12-234) (P/O PL 12.360 Item 1)

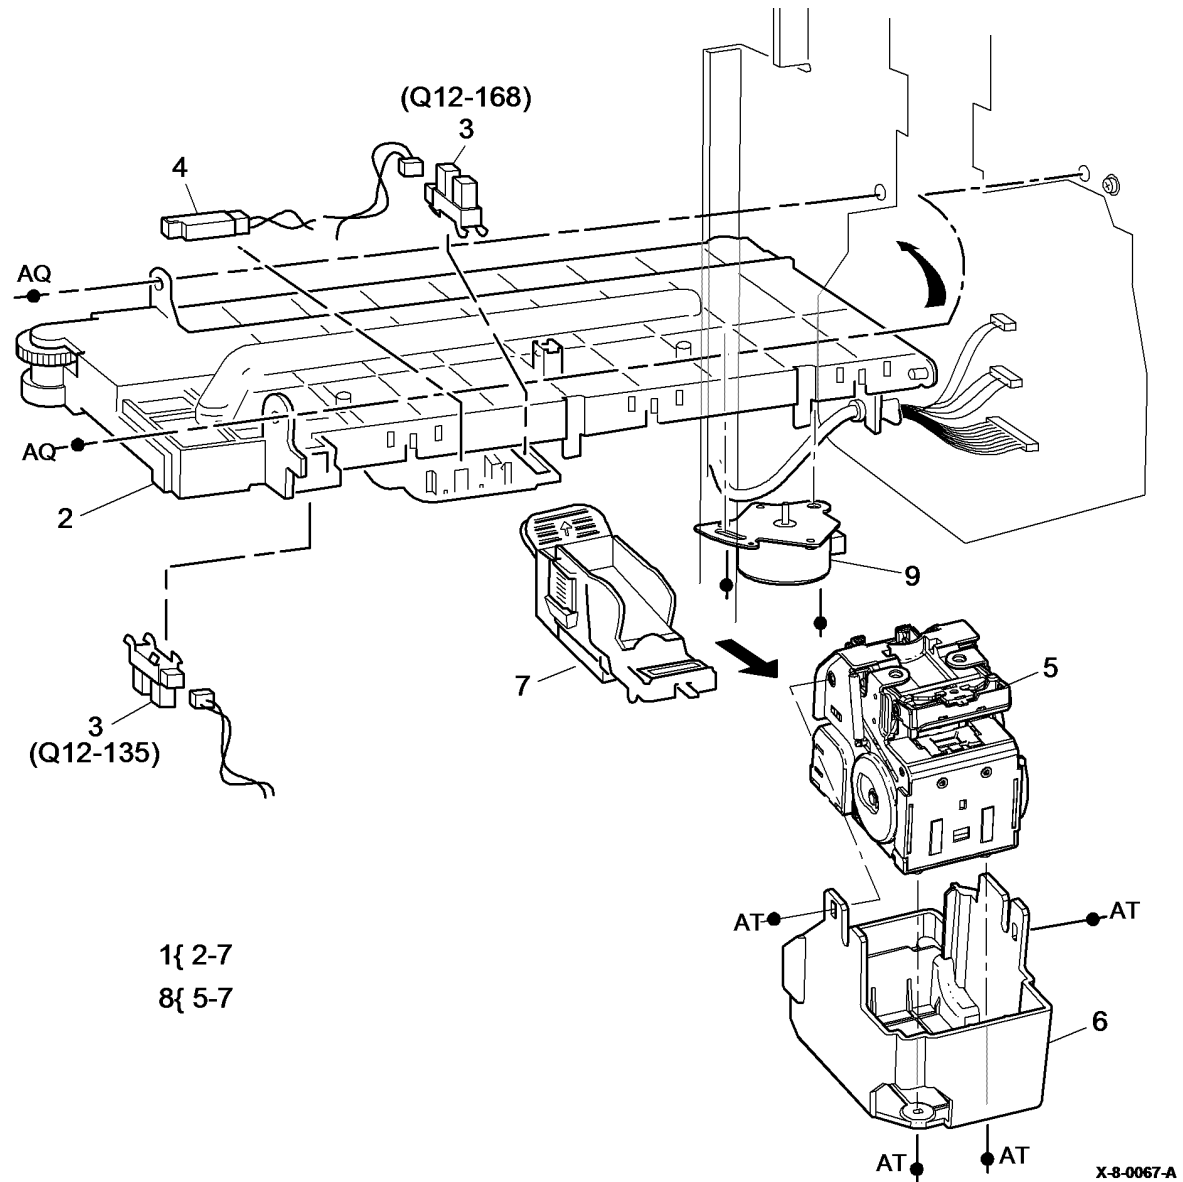
Item	Part	Description
1	014K11544	Stapler traverse assembly (REP 12.8-150)
2	-	Head traverse unit (P/O PL 12.365 Item 1)
3	130E10360	Stapler home sensor (Q12-135), Stapler index sensor (Q12-168) (REP 12.8-150)
4	130E10380	SH1 Paper sensor (Q12-196) (REP 12.8-150)
5	029K04691	Staple head unit (REP 12.9-150)
6	-	Stapler cover (P/O PL 12.365 Item 1)
7	-	Staple cartridge (REF: PL 26.10 Item 11) (See NOTE)
8	-	Staple head assembly (P/O PL 12.365 Item 1)
9	-	Staple unit 1 motor (MOT12-249) (P/O PL 12.365 Item 1)

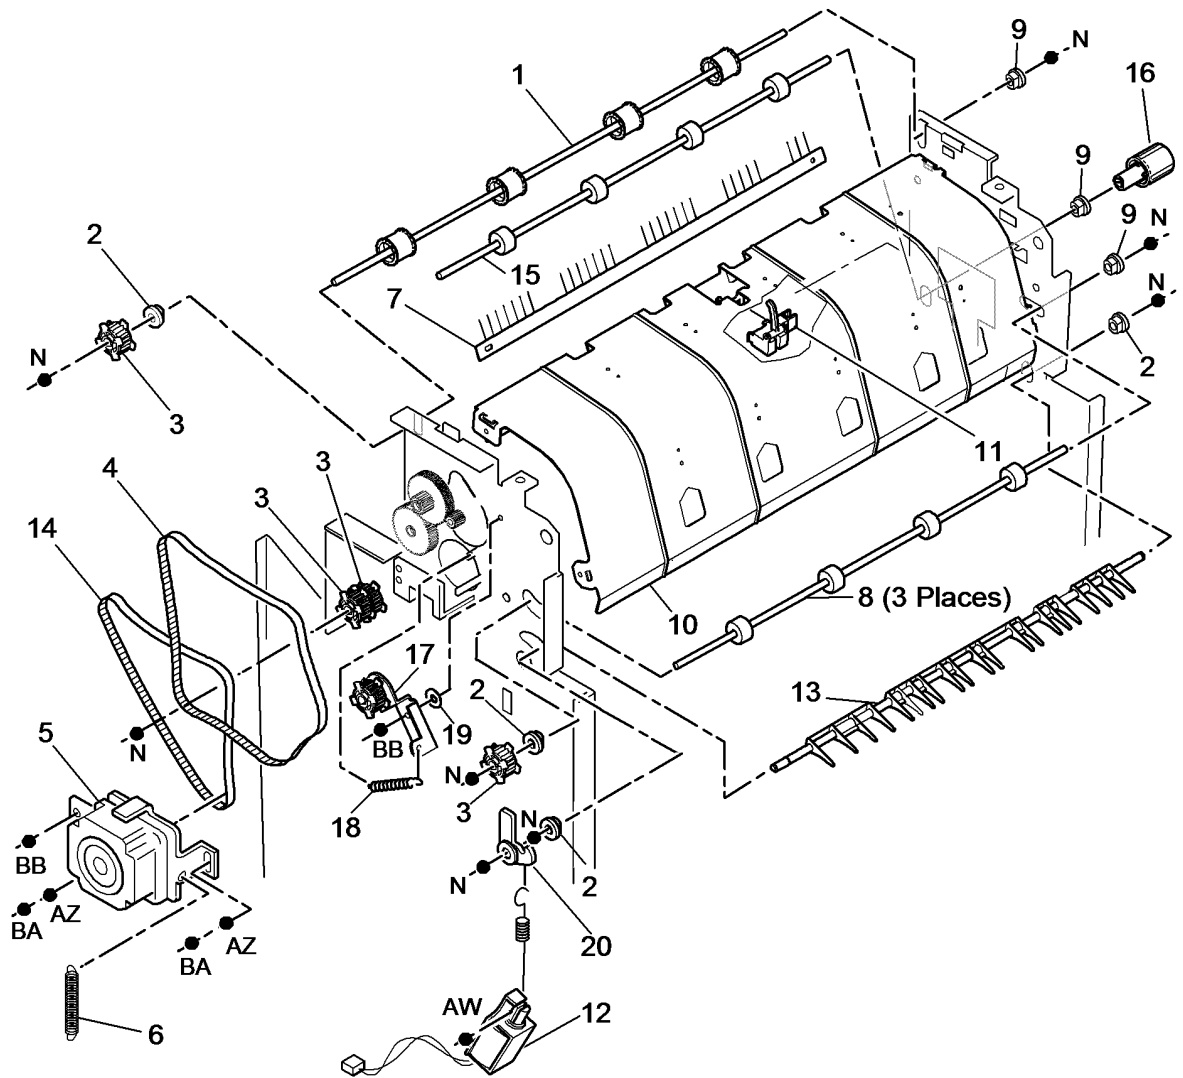
PL 12.370 LVF BM Bin 0 Entry

Item	Part	Description
1	006K32810	Top tray exit shaft
2	013E25790	Nylon bearing
3	-	Pulley (Not Spared)
4	023E24330	Intermediate paper drive belt (REP 12.3-150)
5	127K55870	Transport motor 2 (MOT12-224) (REP 12.4-150, ADJ 12.4-150)
6	-	Spring (Not Spared)
7	115E13440	Static eliminator
8	006K32841	Feed roll shaft (short)
9	013E37460	Bearing
10	117K54510	Paper guide (REP 12.46-150)
11	130E11440	Top tray exit sensor (Q12-107) (REP 12.46-150)
12	121K45010	Exit diverter solenoid (SOL12-225)
13	-	Exit diverter gate (Not Spared)
14	023E24340	Paper output drive belt (REP 12.4-150)
15	006K32800	Drive shaft assembly
16	006K33961	Jam clearance knob
17	-	Belt tensioner (Not Spared) (ADJ 40.1)
18	-	Spring (Not Spared)
19	-	Washer (Not Spared)
20	-	Actuator (Not Spared)
