708P91368
September 2017

Xerox® AltaLink® B8090 Family Multifunction Printer Service Manual

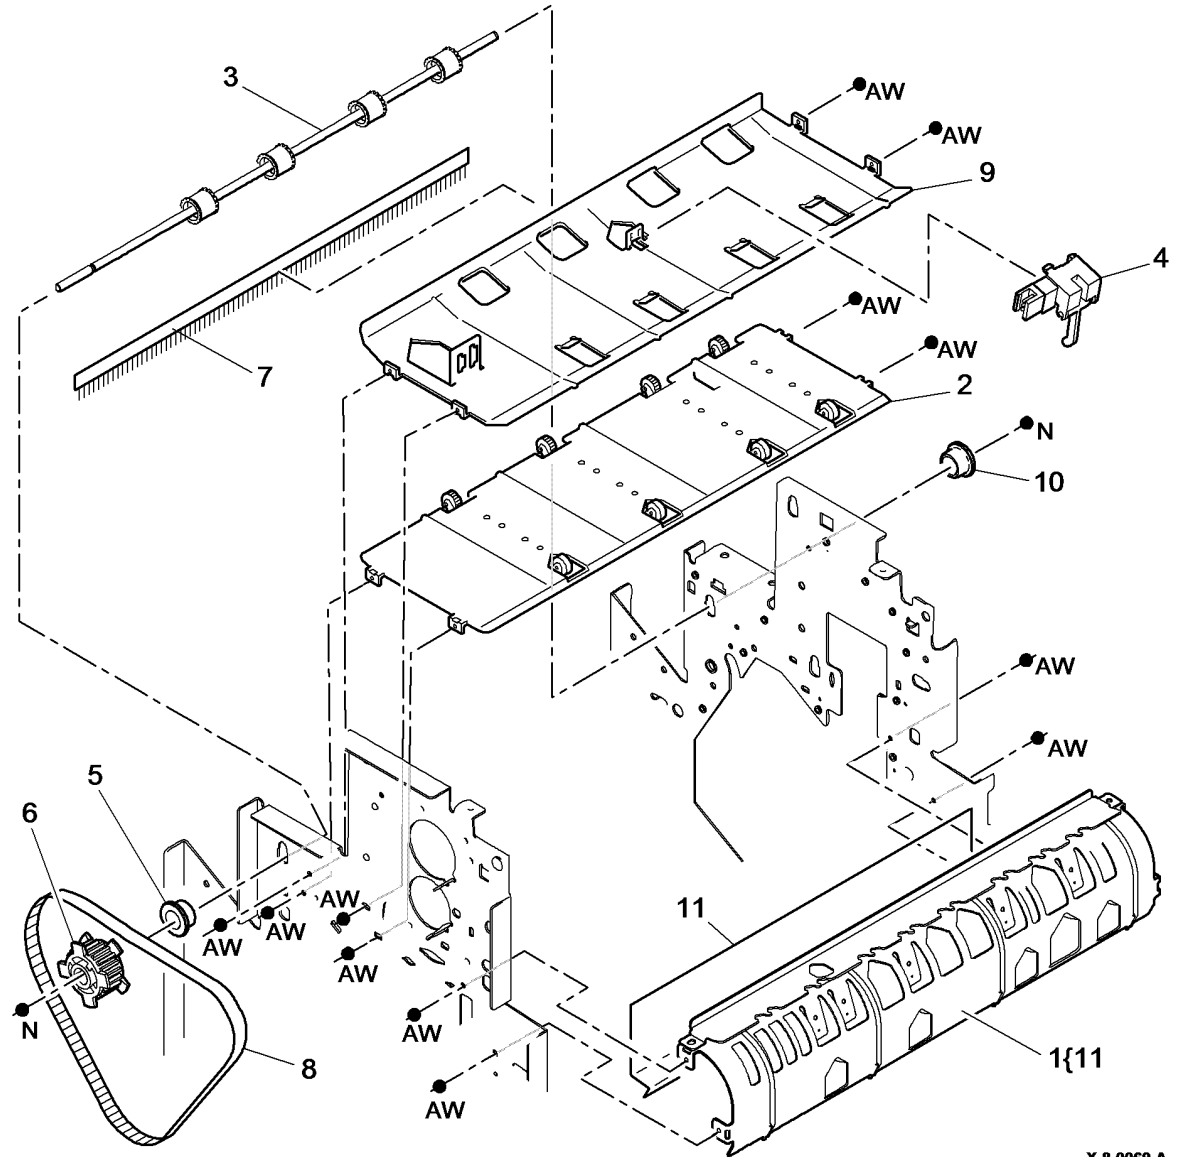
PL 12.375 LVF BM Bin 1 Entry

Item	Part	Description
1	032K04610	Left paper guide
2	-	Lower right paper guide (REP 12.47-150)
3	006K32790	Ejector drive shaft (REP 12.47-150)
4	130E11440	Compiler exit sensor (Q12-106)
5	013E25790	Nylon bearing
6	-	Pulley (Not Spared)
7	115E11810	Static eliminator (stacker)
8	-	Paper output drive belt (REF: PL 12.370 Item 14)
9	-	Upper right paper guide (Not Spared) (REP 12.47-150)
10	013E37460	Bearing
11	-	Mylar safety cover (P/O PL 12.375 Item 1)

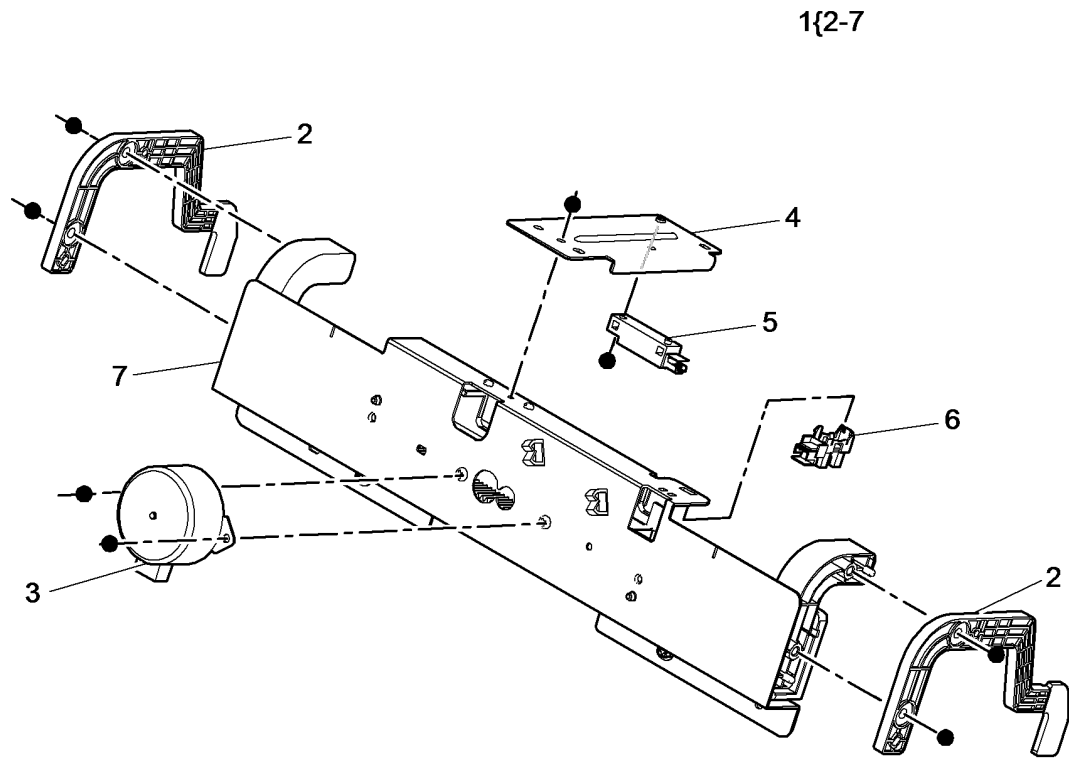
PL 12.380 LVF BM Booklet Tamper Assembly

Item	Part	Description
1	090K02590	Booklet tamper assembly (REP 12.38-150)
2	031E16740	Booklet tamper arm (REP 12.42-150)
3	127E17690	BM Booklet tamper 1 motor (MOT12-256) (REP 12.41-150)
4	–	Sensor bracket (P/O PL 12.380 Item 1)
5	130E10380	BM paper present sensor (Q12-170) (REP 12.43-150)
6	130E10360	BM tamper 1 home sensor (Q12-205) (REP 12.40-150)
7	–	Booklet tamper frame (P/O PL 12.380 Item 1)

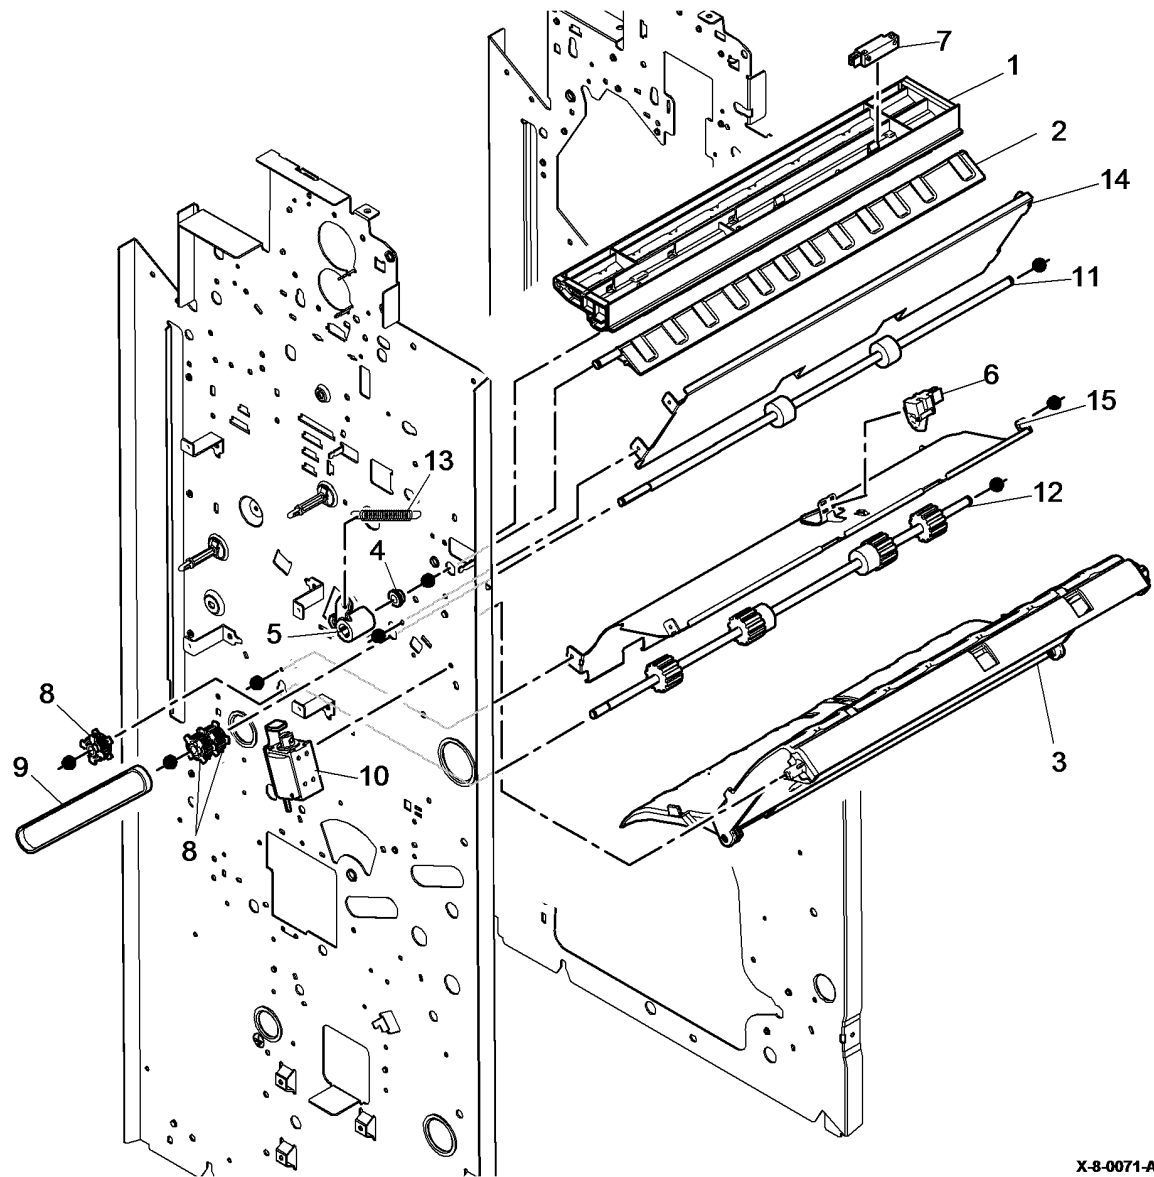
PL 12.385 LVF BM Compiler Entrance Guides

Item	Part	Description
1	-	Upper entrance guide (Not Spared) (REP 12.31-150)
2	850K04150	Booklet diverter gate (REP 12.33-150)
3	032K11720	BM entrance guide assembly (REP 12.32-150)
4	-	Bush (Not Spared)
5	-	Lever (Not Spared)
6	130E21610	BM Entry sensor (Q12-089) (REP 12.32-150)
7	130E10380	Entry sensor (Q12-077) (REP 12.31-150)
8	-	Pulley (Not Spared)
9	-	Compiler entrance drive belt 2 (Not Spared) (REP 12.34-150)
10	121K45010	Booklet diverter gate solenoid (SOL12-258)
11	059K84790	1st feed roll assembly (REP 12.34-150)
12	059K84800	2nd feed roll assembly (REP 12.35-150)
13	-	Spring (Not Spared)
14	-	Upper guide (Not Spared)
15	-	Lower guide (Not Spared) (REP 12.32-150)

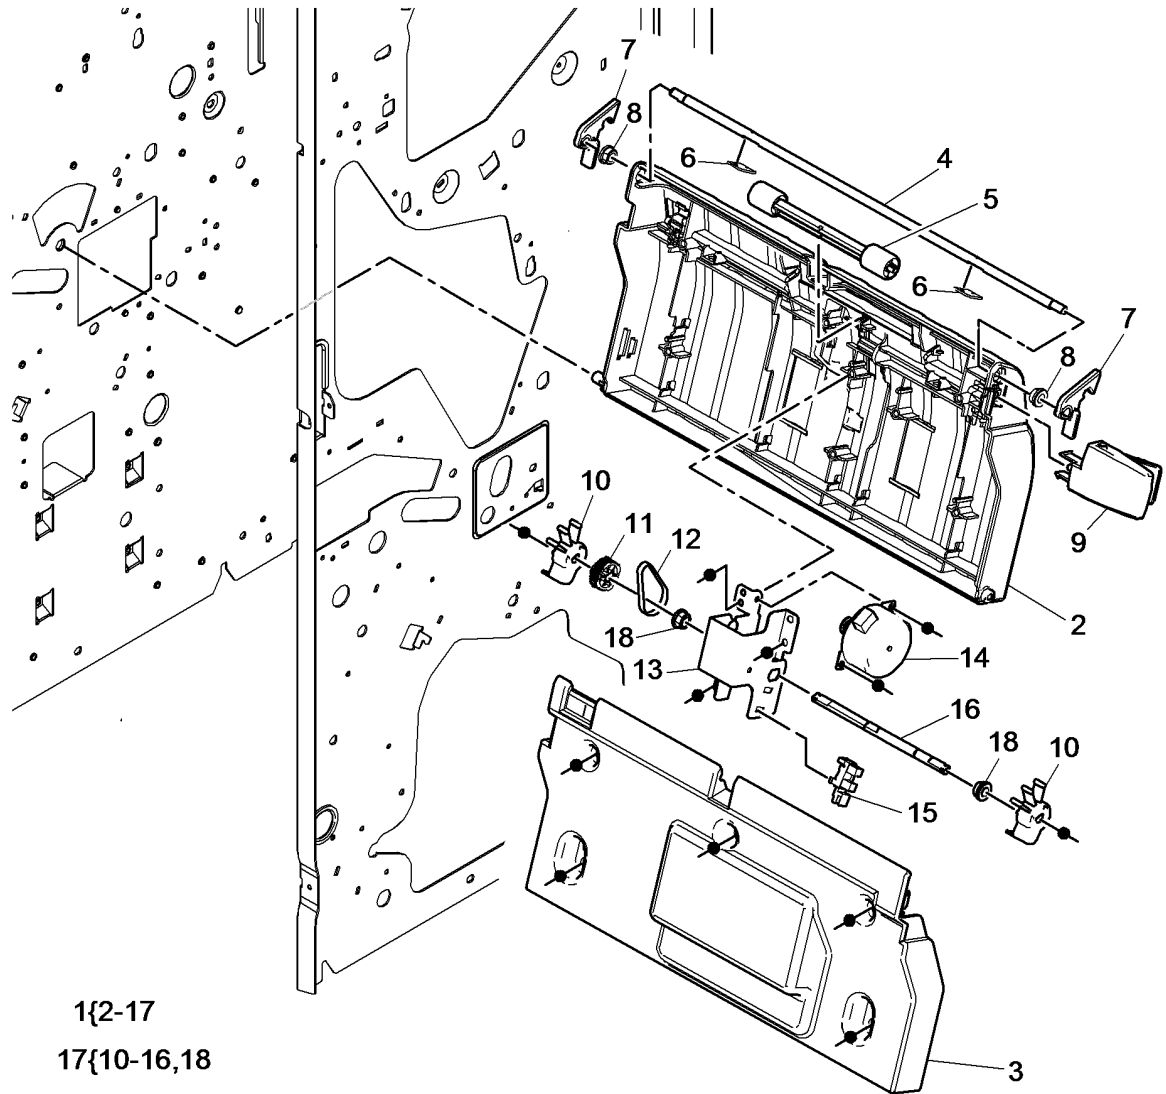
PL 12.390 LVF BM Compiler Guide Assembly

Item	Part	Description
1	055K45241	BM compiler guide assembly (REP 12.30-150)
2	-	Base (P/O PL 12.390 Item 1)
3	-	Cover (P/O PL 12.390 Item 1)
4	-	Shaft (P/O PL 12.390 Item 1)
5	-	Idler roll assembly (P/O PL 12.390 Item 1)
6	-	Static eliminator (P/O PL 12.390 Item 1)
7	-	Latch (P/O PL 12.390 Item 1)
8	-	Bearing (P/O PL 12.390 Item 1)
9	-	Handle (P/O PL 12.390 Item 1)
10	033K05270	BM compiler flapper (REP 12.30-150)
11	-	Pulley (P/O PL 12.390 Item 1)
12	-	Belt (P/O PL 12.390 Item 1)
13	-	Bracket (P/O PL 12.390 Item 1)
14	-	BM Flapper motor (MOT12-271) (P/O PL 12.390 Item 1)
15	130E10360	BM Flapper home sensor (Q12-207)
16	-	Drive shaft (P/O PL 12.390 Item 1)
17	055K44530	BM Flapper motor assembly (REP 12.30-150)
18	-	Bearing (P/O PL 12.390 Item 17)

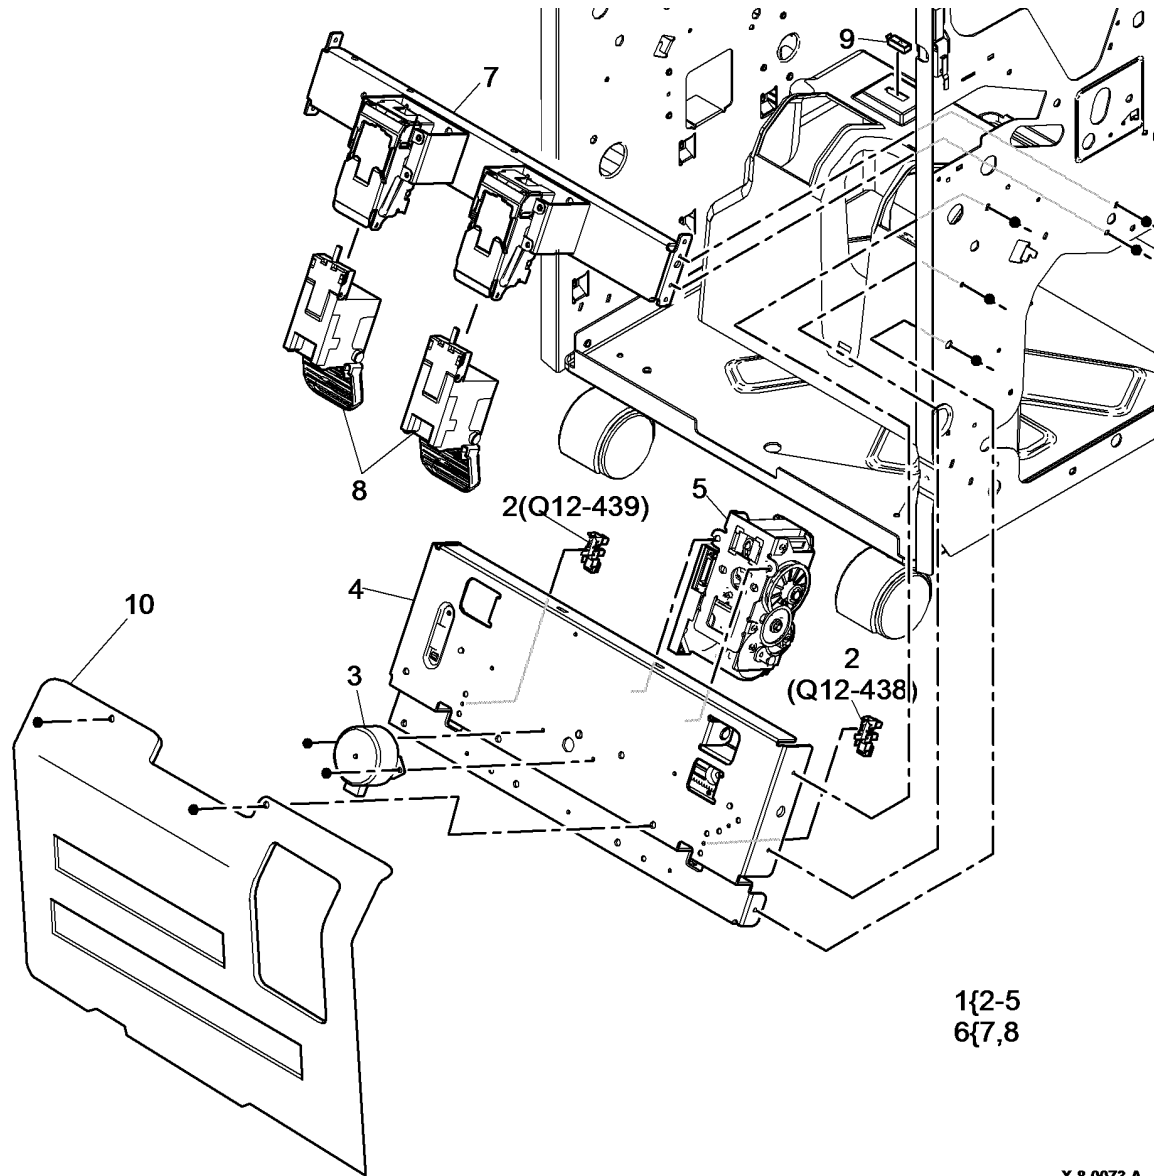
PL 12.395 LVF BM Booklet Stapler Assembly

Item	Part	Description
1	029K04812	BM stapler assembly (REP 12.38-150)
2	130E10360	Staple head home sensor (Q12-438)/Staple head away sensor (Q12-439) (REP 12.48-150)
3	127E17680	BM staple unit move motor (MOT12-435)
4	-	BM stapler frame (P/O PL 12.395 Item 1)
5	077E00081	BM staple head assembly (REP 12.48-150)
6	029K04800	BM staple cartridge assembly (REP 12.37-150)
7	-	Bracket (P/O PL 12.395 Item 6)
8	-	Staple cartridge (REF: PL 26.11 Item 2)
9	107E35740	Staple cartridge LED (REP 12.39-150)
10	822E18810	LVF BM Back stop cover (REP 12.1-150)

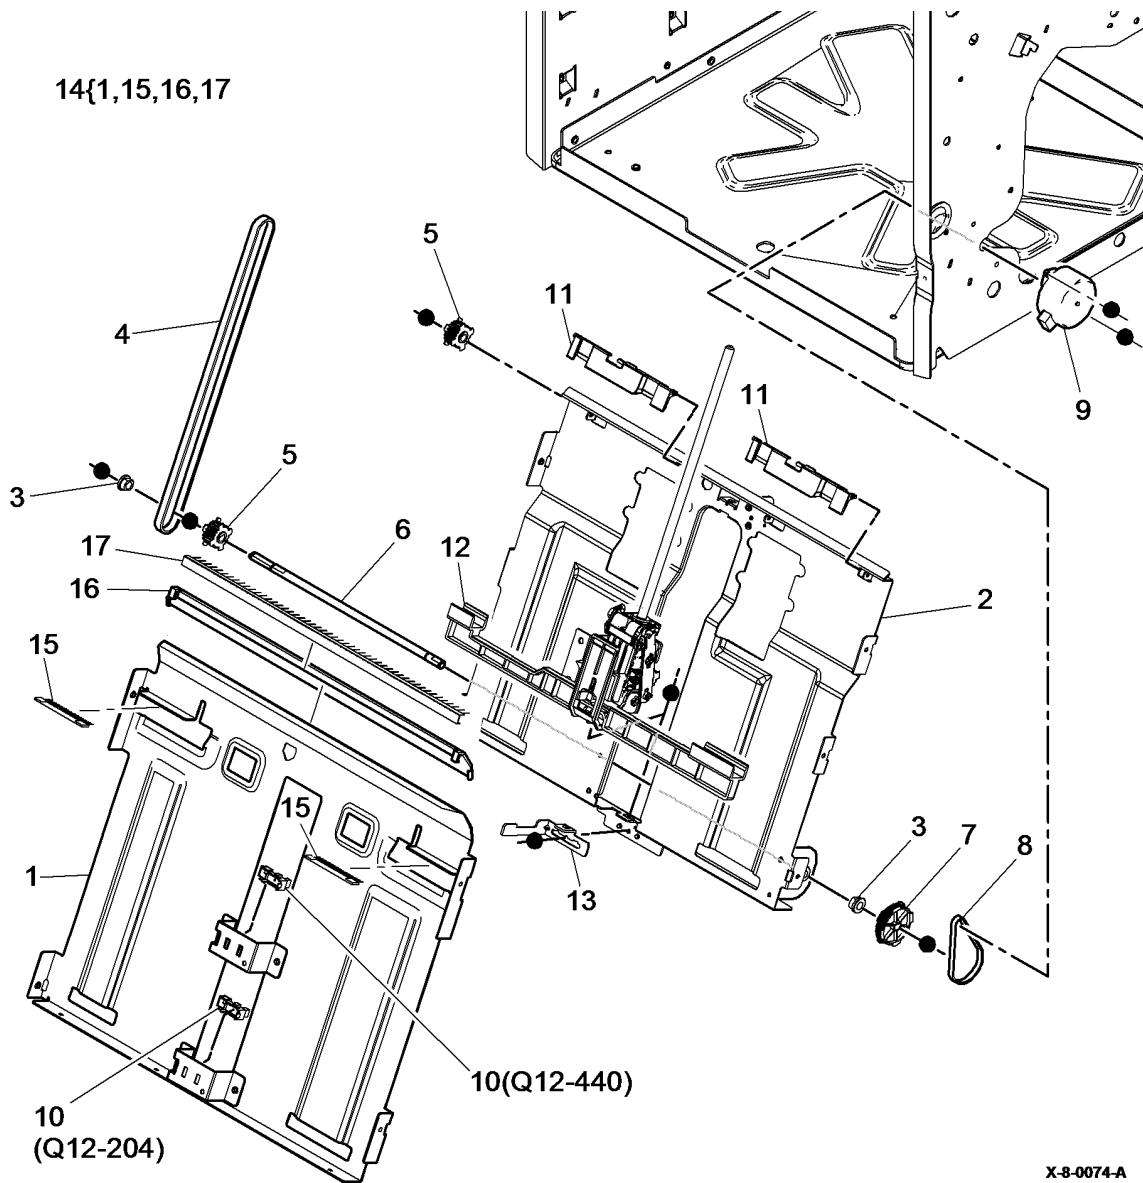
Item	Part	Description
1	-	Left guide (P/O PL 12.400 Item 14) (REP 12.19-150)
2	-	Right guide (Not Spared) (REP 12.19-150)
3	016E21260	Bearing
4	-	Belt (Not Spared)
5	-	Pulley (Not Spared)
6	-	Shaft (Not Spared)
7	-	Drive pulley (Not Spared)
8	-	Drive Belt (Not Spared)
9	127K74620	BM Back stop motor (MOT12-255) (REP 12.18-150)
10	130E10360	BM guide home sensor (Q12-204)/ BM back stop mid home sensor (Q12-440) (REP 12.20-150)
11	-	Stapler stop guide (Not Spared)
12	674K08890	Back stop assembly (REP 12.19-150)
13	-	Bracket (Not Spared)
14	674K09350	Back stop left guide assembly (REP 12.19-150)
15	115E13910	Static eliminator (REP 12.19-150)
16	822E33440	Sub plate (See NOTE) (REP 12.19-150)
17	-	Static eliminator (P/O PL 12.400 Item 14)

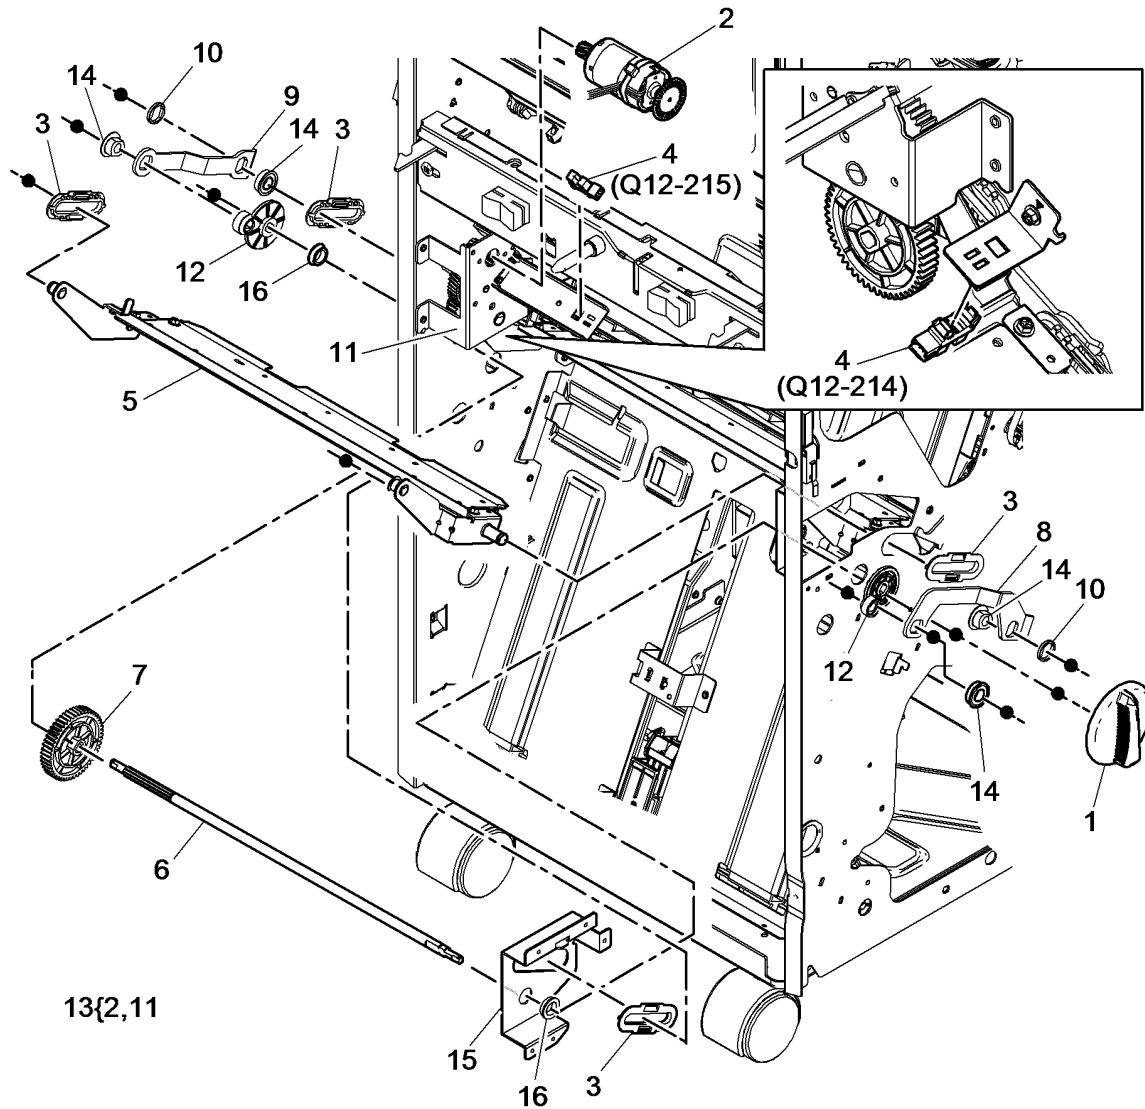
PL 12.405 LVF BM Crease Blade Assembly

Item	Part	Description
1	803E20901	Crease blade handle (REP 12.23-150)
2	127E17650	BM Crease blade motor (MOT12-252) (REP 12.21-150)
3	011E30810	Crease blade guide (REP 12.22-150)
4	130E10360	BM Crease blade home sensor (Q12-214)/BM Crease blade motor encoder sensor (Q12-215) (REP 12.21-150)
5	037K01490	Crease blade assembly (REP 12.22-150)
6	-	Crease blade shaft (Not Spared)
7	807E46760	Crease blade drive gear (REP 12.23-150)
8	-	Front blade arm (Not Spared)
9	-	Rear blade arm (Not Spared)
10	-	Spacer (Not Spared)
11	-	Crease blade gearbox assembly (P/O PL 12.405 Item 13) (REP 12.21-150)
12	008E08860	Blade crank (REP 12.23-150)
13	007K20511	Crease blade motor assembly (REP 12.21-150)
14	016E21260	Crease blade bearing (REP 12.23-150)
15	-	Bracket (Not Spared)
16	013E43930	Crease blade shaft bearing

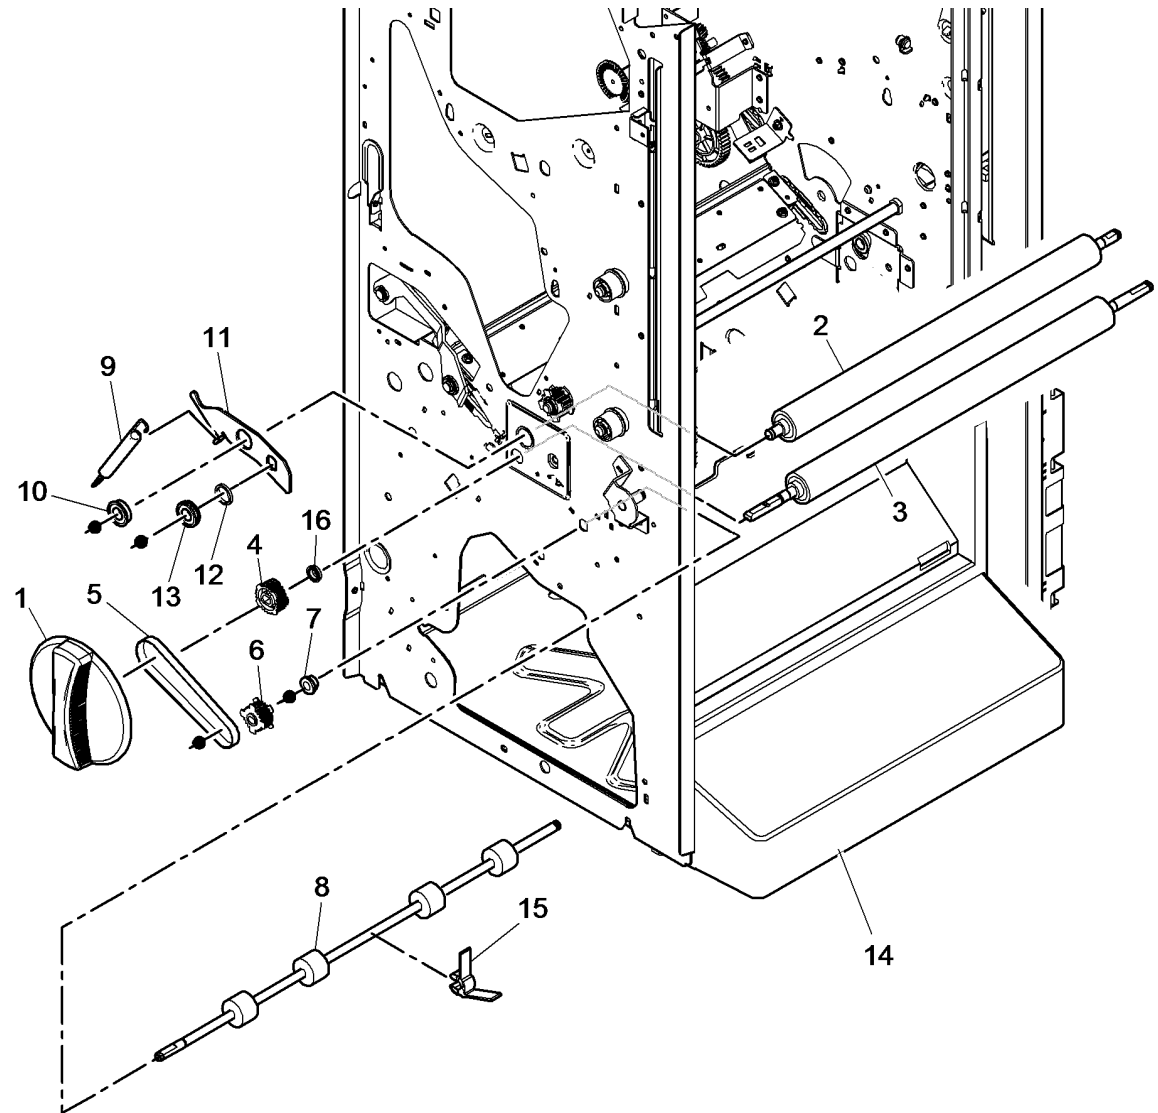
PL 12.410 LVF BM Crease Roll Assembly (1 of 3)

Item	Part	Description
1	803E20911	Crease roll handle (REP 12.24-150)
2	059E11860	Upper crease roll (See NOTE) (REP 12.24-150)
3	059E11870	Lower crease roll (REP 12.24-150)
4	020E55510	Crease roll handle pulley (REP 12.24-150)
5	023E32470	Exit roll belt (REP 12.27-150)
6	020E55520	Exit roll pulley (REP 12.27-150)
7	016E21260	Bush (REP 12.27-150)
8	059K84780	BM exit roll assembly (REP 12.27-150)
9	899E07760	Crease roll spring (x2) (REP 12.24-150)
10	013E43940	Crease roll bearing (REP 12.24-150)
11	031E16710	Front crease roll lever (REP 12.24-150)
12	-	Spacer (Not Spared)
13	-	Bearing (Not Spared)
14	-	Bin 2 support (Not Spared) (REP 12.44-150)
15	-	Exit roll paddle (Not Spared) (REP 12.27-150)
16	013E43930	Lower crease roll bearing

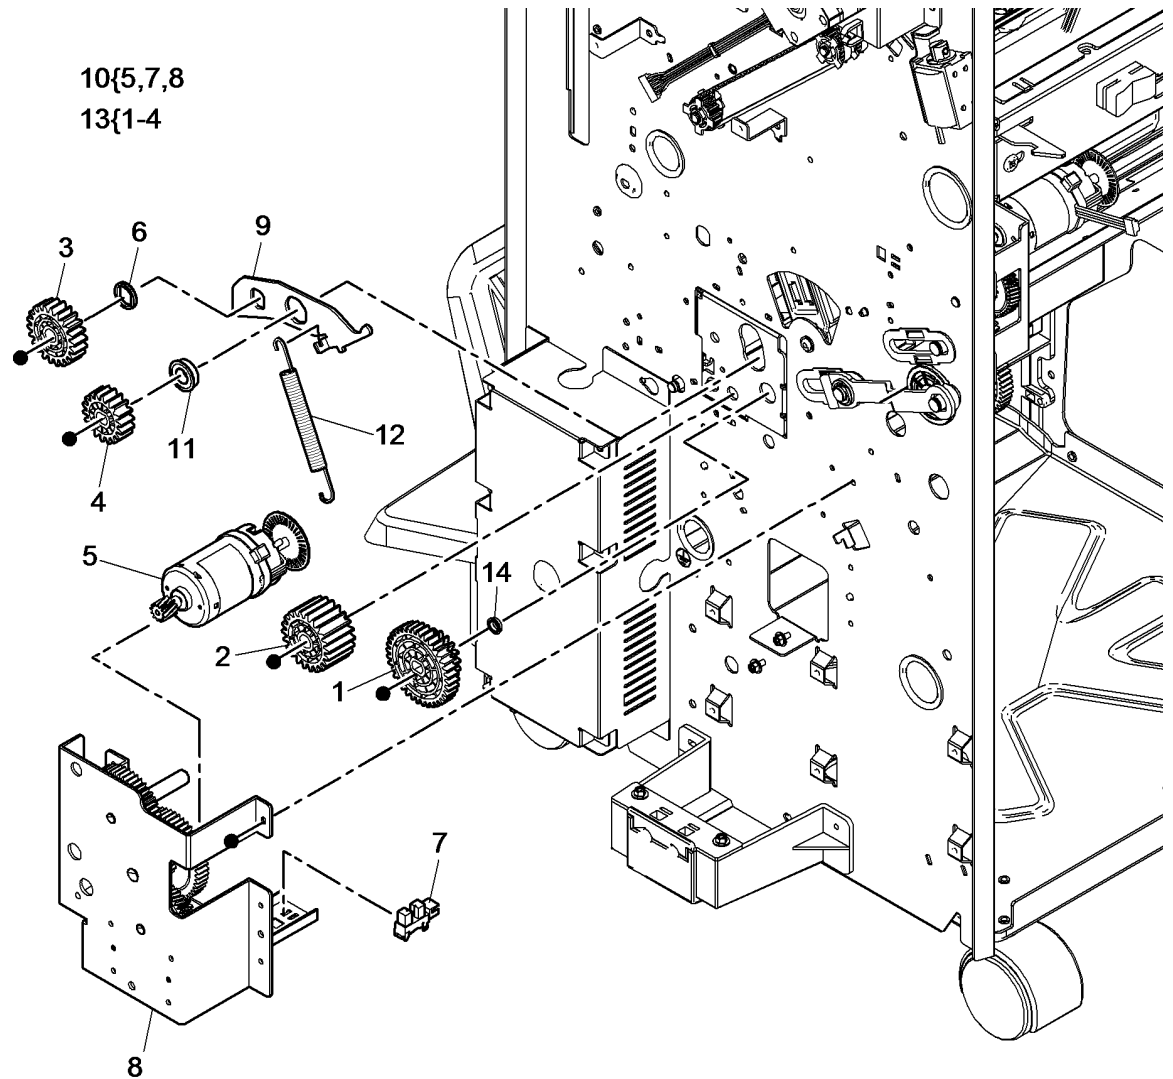
PL 12.415 LVF BM Crease Roll Assembly (2 of 3)

Item	Part	Description
1	-	Crease roll gear 1 (P/O PL 12.415 Item 13) (REP 12.26-150)
2	-	Crease roll gear 2 (P/O PL 12.415 Item 13) (REP 12.26-150)
3	-	Crease roll gear 3 (P/O PL 12.415 Item 13) (REP 12.26-150)
4	-	Crease roll gear 4 (P/O PL 12.415 Item 13) (REP 12.26-150)
5	-	BM Crease roll motor (MOT12-253) (P/O PL 12.415 Item 10) (REP 12.25-150)
6	-	Spacer (Not Spared)
7	130E10360	BM crease roll motor encoder sensor (Q12-216) (REP 12.25-150)
8	-	Crease roll gearbox assembly (P/O PL 12.415 Item 10)
9	031E16720	Rear crease roll lever (REP 12.24-150)
10	007K20520	Crease roll motor and gearbox assembly (REP 12.25-150)
11	013E43940	Crease roll bearing (REP 12.24-150)
12	899E07760	Crease roll spring (x2) (REP 12.24-150)
13	807E46770	Crease roll gear kit (REP 12.26-150)
14	013E43930	Lower crease roll bearing

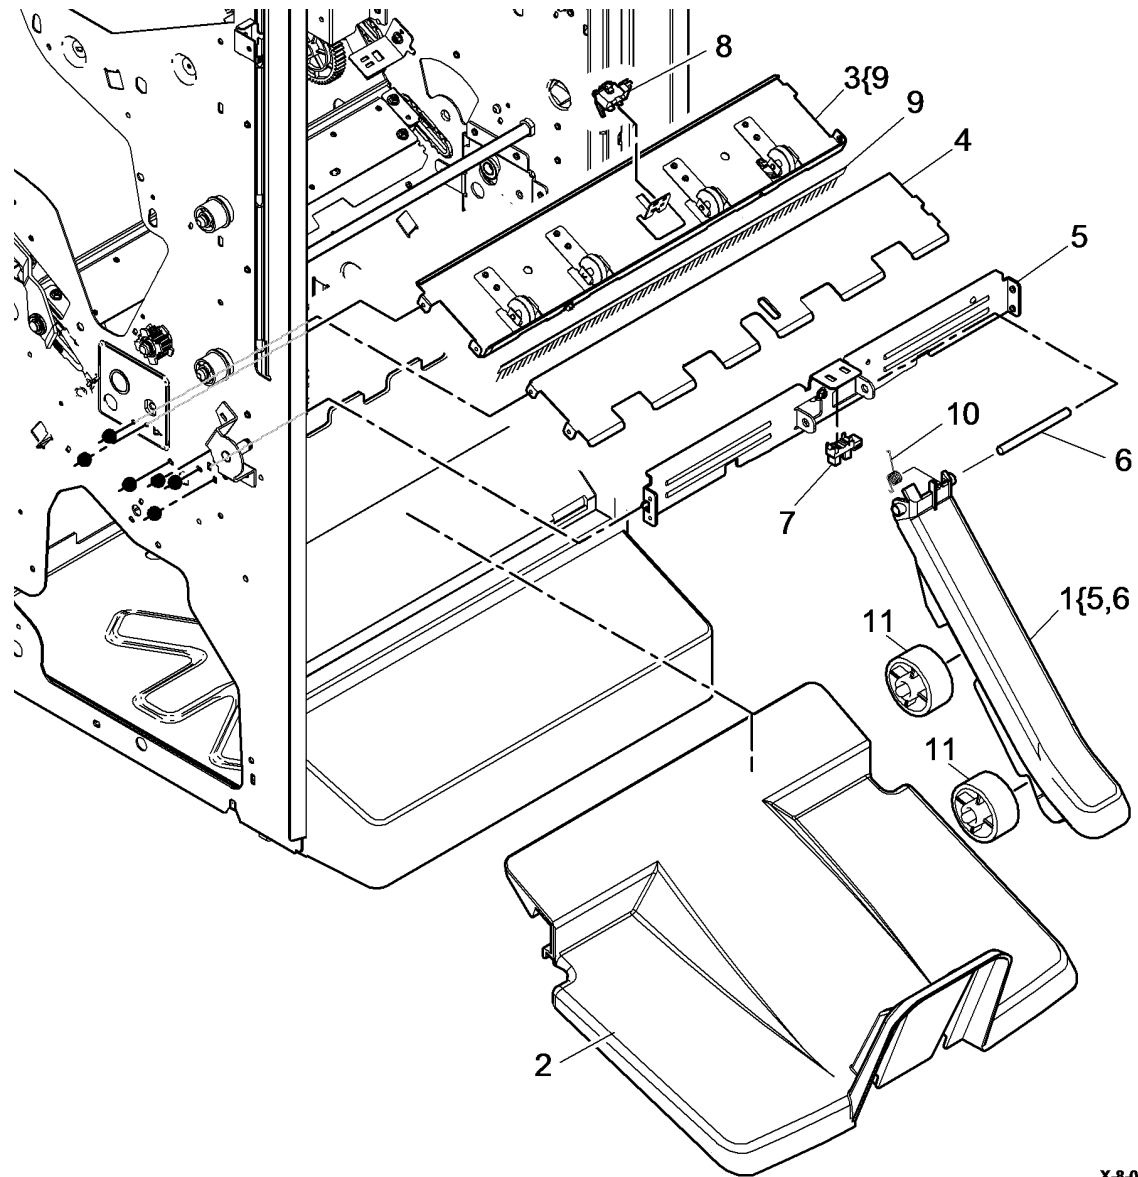
PL 12.420 LVF BM Crease Roll Assembly (3 of 3)

Item	Part	Description
1	031K09230	Bail arm assembly (REP 12.29-150)
2	050E29400	Bin 2
3	032K10330	Exit upper guide assembly (REP 12.28-150)
4	-	Exit lower guide (Not Spared)
5	-	Bail arm support bracket (P/O PL 12.420 Item 1)
6	-	Bail arm pin (P/O PL 12.420 Item 1)
7	130E10360	Bin 2 90% full sensor (Q12-206) (REP 12.29-150)
8	868E93710	BM exit sensor (Q12-213) (REP 12.28-150)
9	-	Static eliminator (P/O PL 12.420 Item 3)
10	899E07770	Bail arm spring (REP 12.29-150)
11	059E11880	Bail arm roller (x2) (REP 12.29-150)

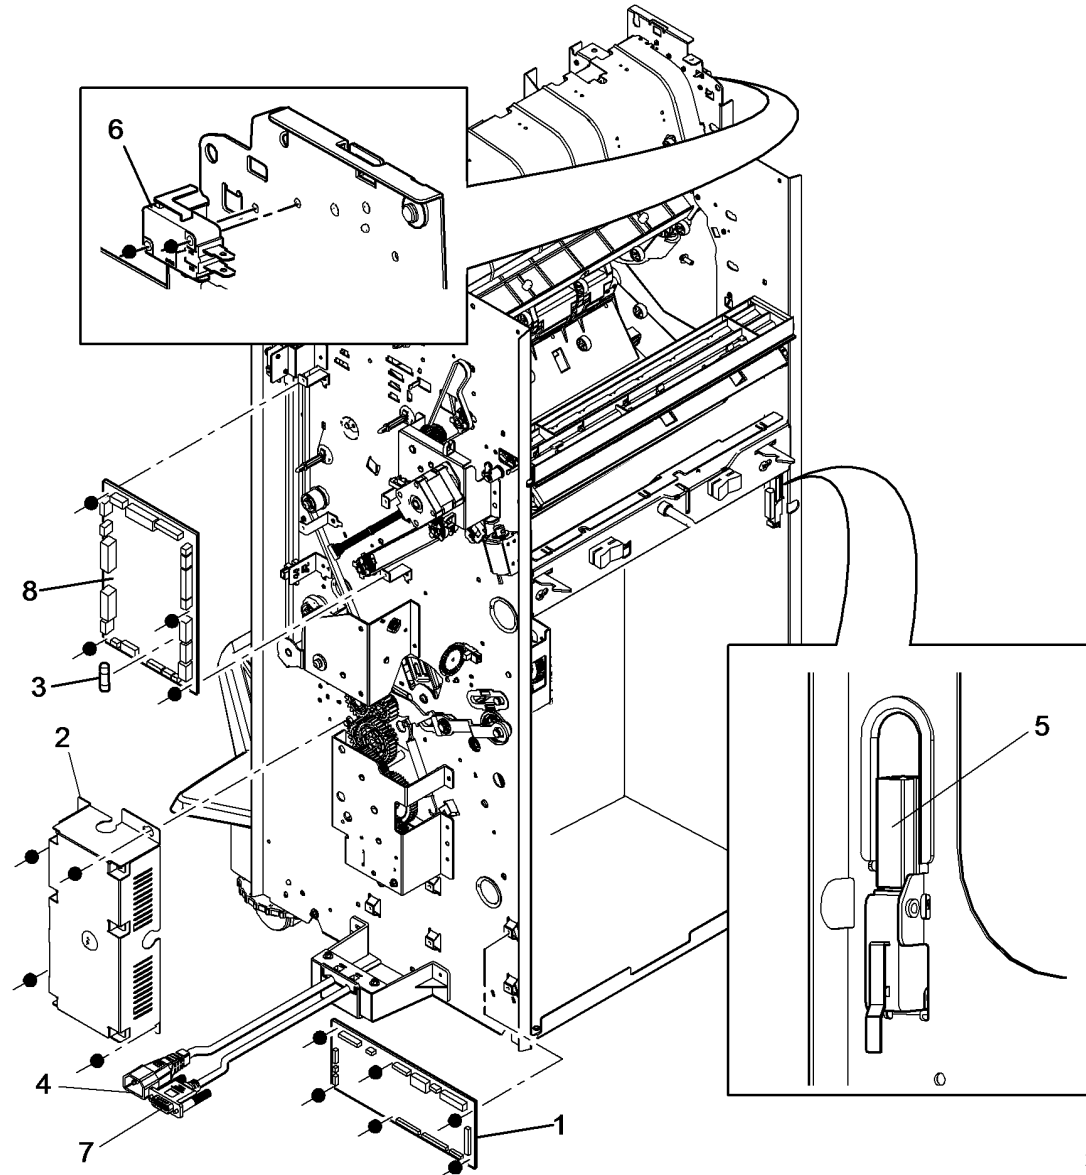
PL 12.425 LVF BM Electrical

Item	Part	Description
1	960K83180	LVF BM PWB (REP 12.36-150)
2	105E24900	Power supply module
3	–	Fuse (Not Spared)
4	–	Power cable (Not Spared)
5	110K13980	Front door interlock switch (S12-303)
6	110K13970	Top cover interlock switch (S12-197)
7	–	Communications cable (Not Spared)
8	960K97500	LVF PWB (REP 12.14-150)

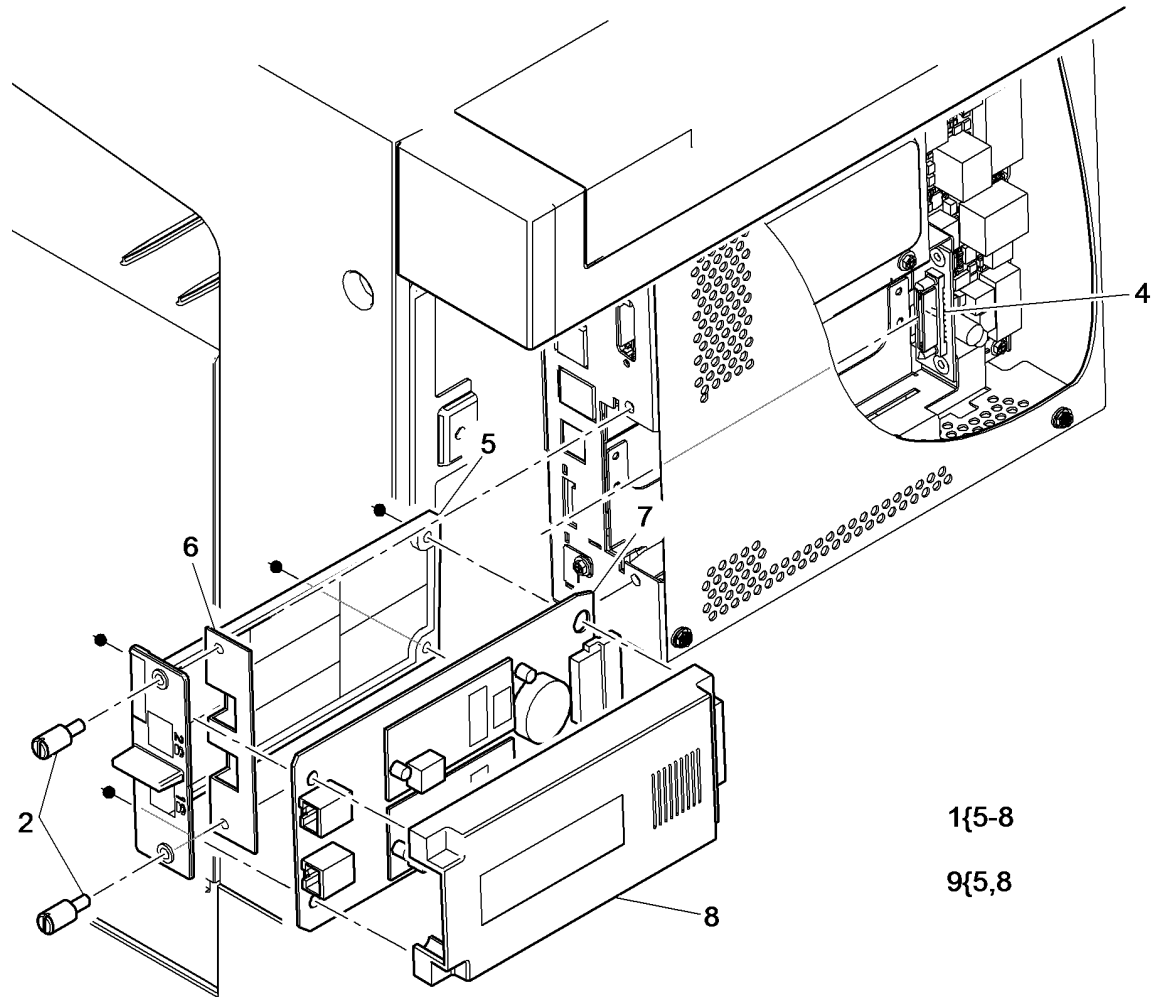
PL 20.05 Fax Module

Item	Part	Description
1	-	Fax module
-	-	1 line (P/O PL 31.35 Item 1)
-	-	2 line (P/O PL 31.40 Item 1)
2	-	Thumbscrew (Not Spared)
3	-	Telephone cable - see variants below (not shown on illustration)(Not Spared)
-	-	USSG/XCL
-	-	United Kingdom
-	-	Germany
-	-	Italy
-	-	Netherlands
-	-	Belgium
-	-	Switzerland
-	-	Denmark
-	-	Austria
-	-	Sweden
-	-	France
-	-	Norway
-	-	Portugal/Spain
-	-	Finland
4	960K73340	Fax connector PWB
5	-	Front cover (P/O PL 20.05 Item 9) (REP 20.1)
6	-	Ground plate (P/O PL 20.05 Item 1)
7	-	Fax PWB (see below for variants) (REP 20.1)
-	-	1 line Cfax34 (P/O PL 31.35 Item 2) (REP 20.1)
-	-	2 line Cfax34 (P/O PL 31.40 Item 2) (REP 20.1)
8	-	Rear cover (P/O PL 20.05 Item 9) (REP 20.1)
9	848E74310	Covers assembly (REP 20.1)

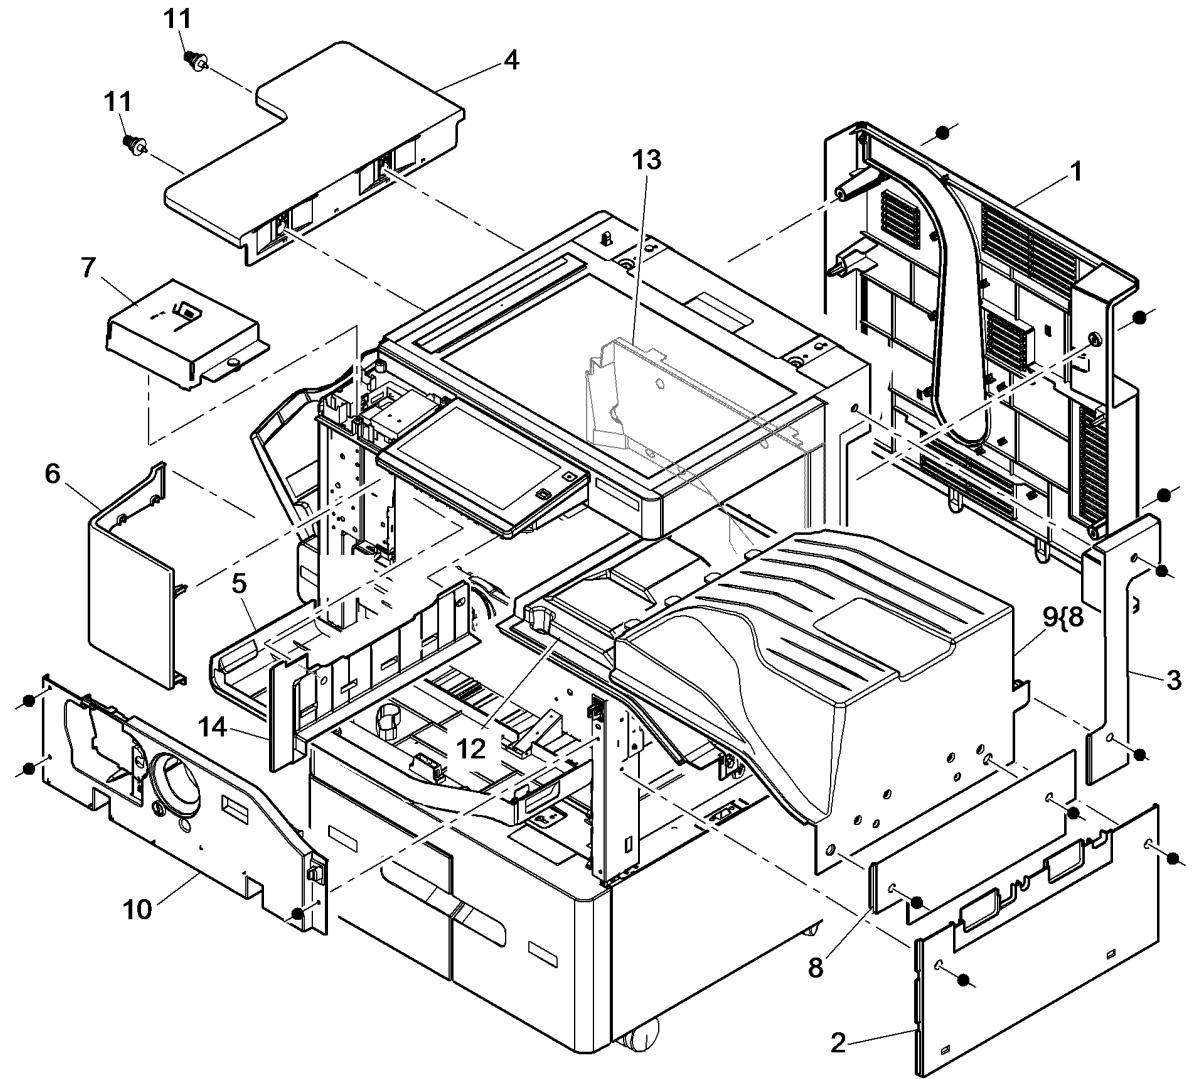
Item	Part	Description
1	948K30491	Rear cover (45-55ppm) (REP 28.2)
-	948K30503	Rear cover (REF: PL 10.9) (65-90 ppm) (See NOTE)
2	-	Right cover (Not Spared)
3	-	Upper right cover (Not Spared) (REP 28.1)
4	-	Work shelf (P/O PL 31.11 Item 13)
5	-	Front door assembly (REF: PL 28.11)
6	822E44753	Left frame cover (REP 28.1)
7	-	Left column upper cover (REF: PL 2.10 Item 9)
8	-	Centre output tray blanking cover (P/O PL 28.10 Item 9)
9	-	Centre output tray (P/O PL 31.14 Item 16) (REP 10.9)
10	948K24482	Inner front cover
11	-	Thumbscrew (P/O PL 28.10 Item 4)
12	-	Inner machine cover (Not Spared) (REP 28.3)
13	-	Back plate (Not Spared)
14	-	Left inside cover (Not Spared)

NOTE: This rear cover assembly also contains PL 10.9 Items 1-13.

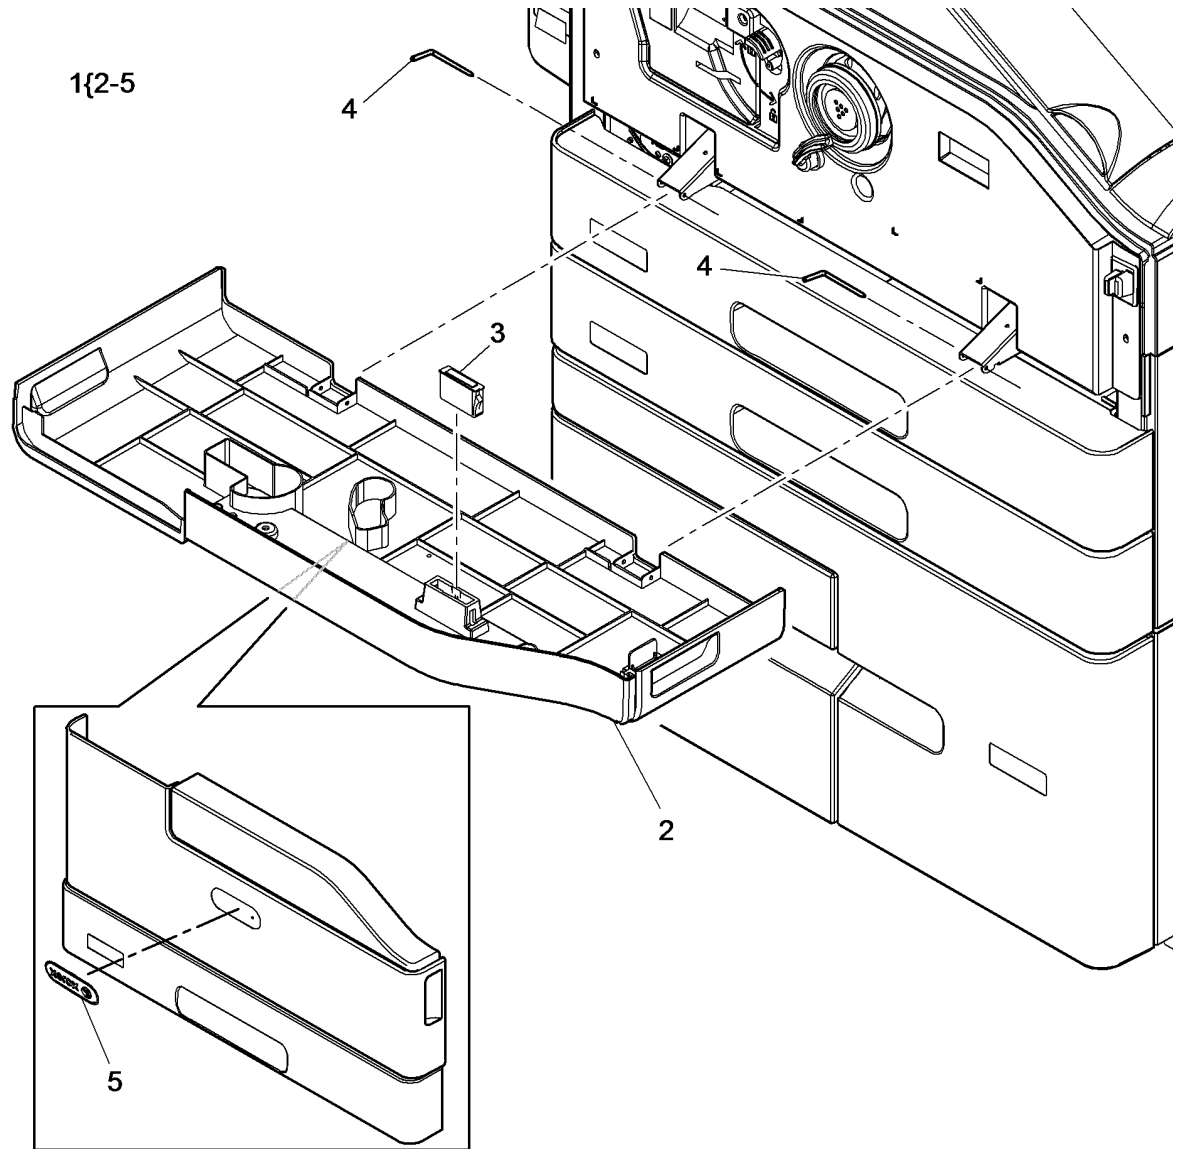
PL 28.11 Front Door Assembly

Item	Part	Description
1	948K24523	Front door assembly
2	-	Front cover assembly (P/O PL 28.11 Item 1)
3	-	Magnet (P/O PL 28.11 Item 1)
4	-	Door hinge pin (P/O PL 28.11 Item 1)
5	-	Logo badge (P/O PL 28.11 Item 1)

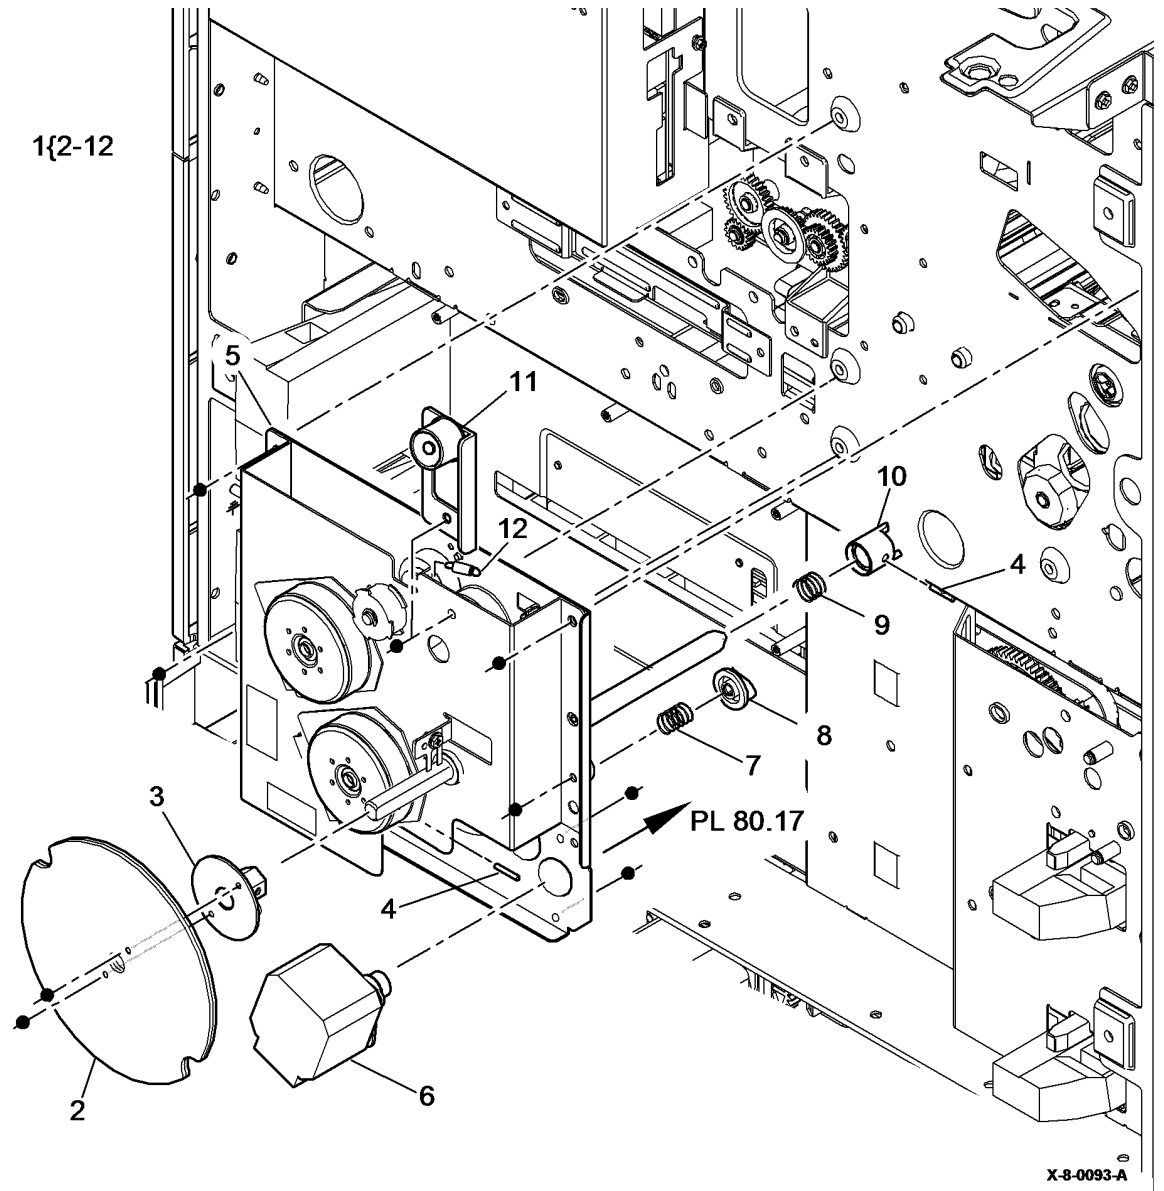
PL 40.15 Main Drive Module

Item	Part	Description
1	007K20788	Main drive module (45-55 ppm) (REP 40.1, ADJ 40.1)
-	007K28170	Main drive module (65-90 ppm) (REP 40.1, ADJ 40.1)
2	-	Flywheel (P/O PL 40.15 Item 1)
3	-	Flywheel clamp (P/O PL 40.15 Item 1)
4	-	Dowel pin (P/O PL 40.15 Item 1)
5	-	Main drive unit (P/O PL 40.15 Item 1)
6	127E17792	Registration motor (REP 40.2)
7	-	Spring (P/O PL 40.15 Item 1)
8	-	Developer dog gear (P/O PL 40.15 Item 1)
9	-	Spring (P/O PL 40.15 Item 1)
10	-	Photoreceptor dog gear (P/O PL 40.15 Item 1)
11	-	Tensioner (P/O PL 40.15 Item 1)
12	-	Tension spring (P/O PL 40.15 Item 1)
