708P91368
September 2017

Xerox® AltaLink® B8090 Family Multifunction Printer Service Manual

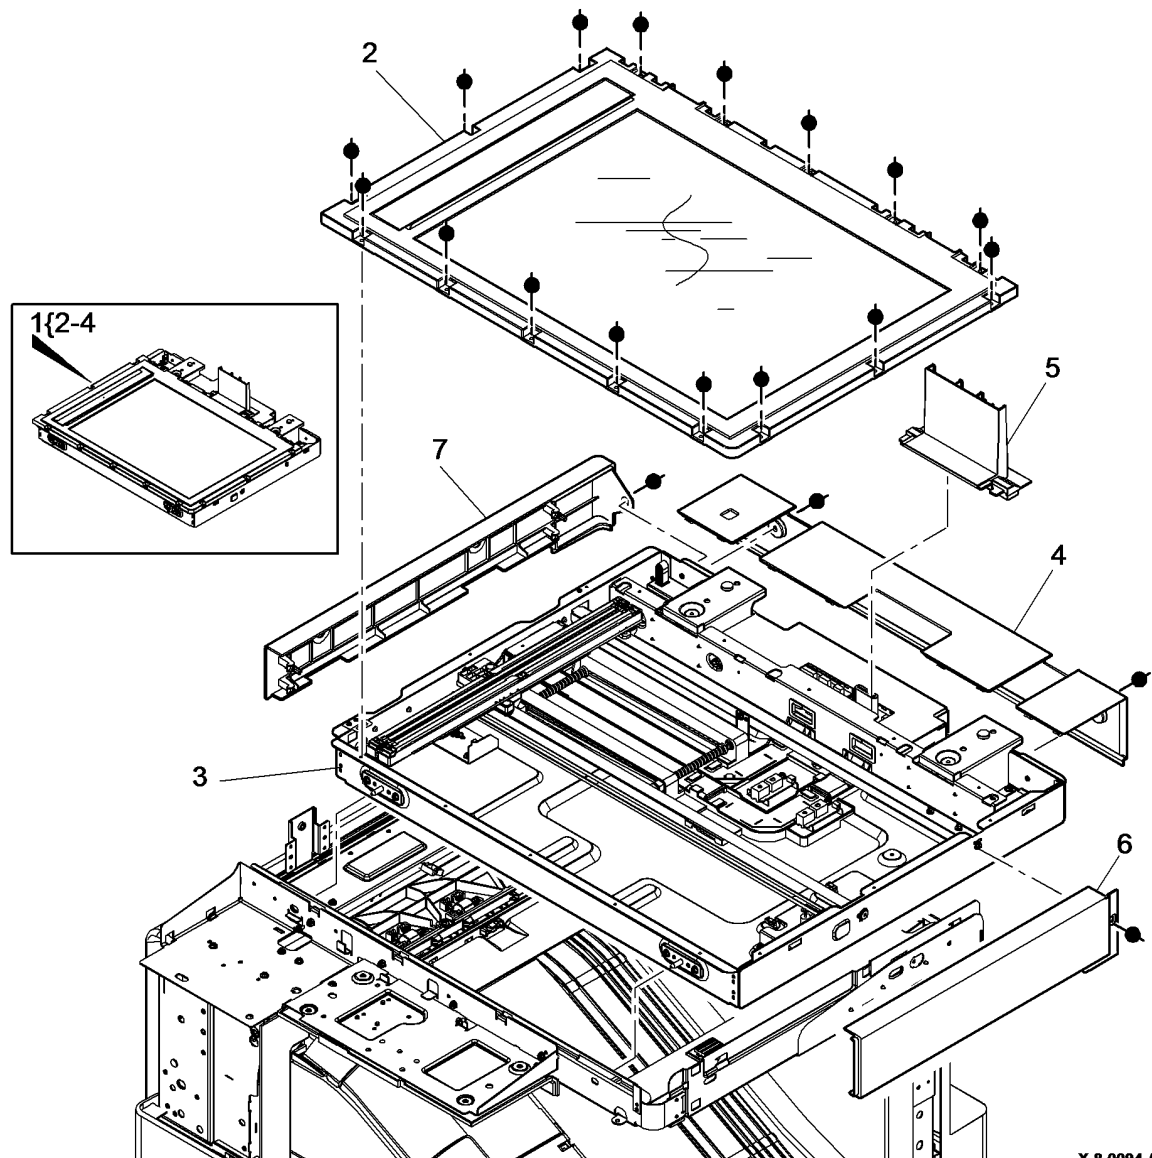
PL 60.15 Scanner Module, CVT/ Document Glass

Item	Part	Description
1	062K31110	Scanner module (REP 60.2)
2	948K29440	Top cover assembly (See NOTE 2) (REP 60.3)
3	–	Base (P/O PL 60.15 Item 1)
4	–	Rear cover (REP 60.1)
5	–	SPDH harness guide (P/O PL 60.15 Item 1)
6	–	Right cover (P/O PL 60.15 Item 1)
7	–	Left cover (P/O PL 60.15 Item 1)

NOTE: 1.Refer to ADJ 60.1 for the scanner cleaning procedure.

NOTE: 2.The top cover assembly includes the CVT glass and the platen glass.

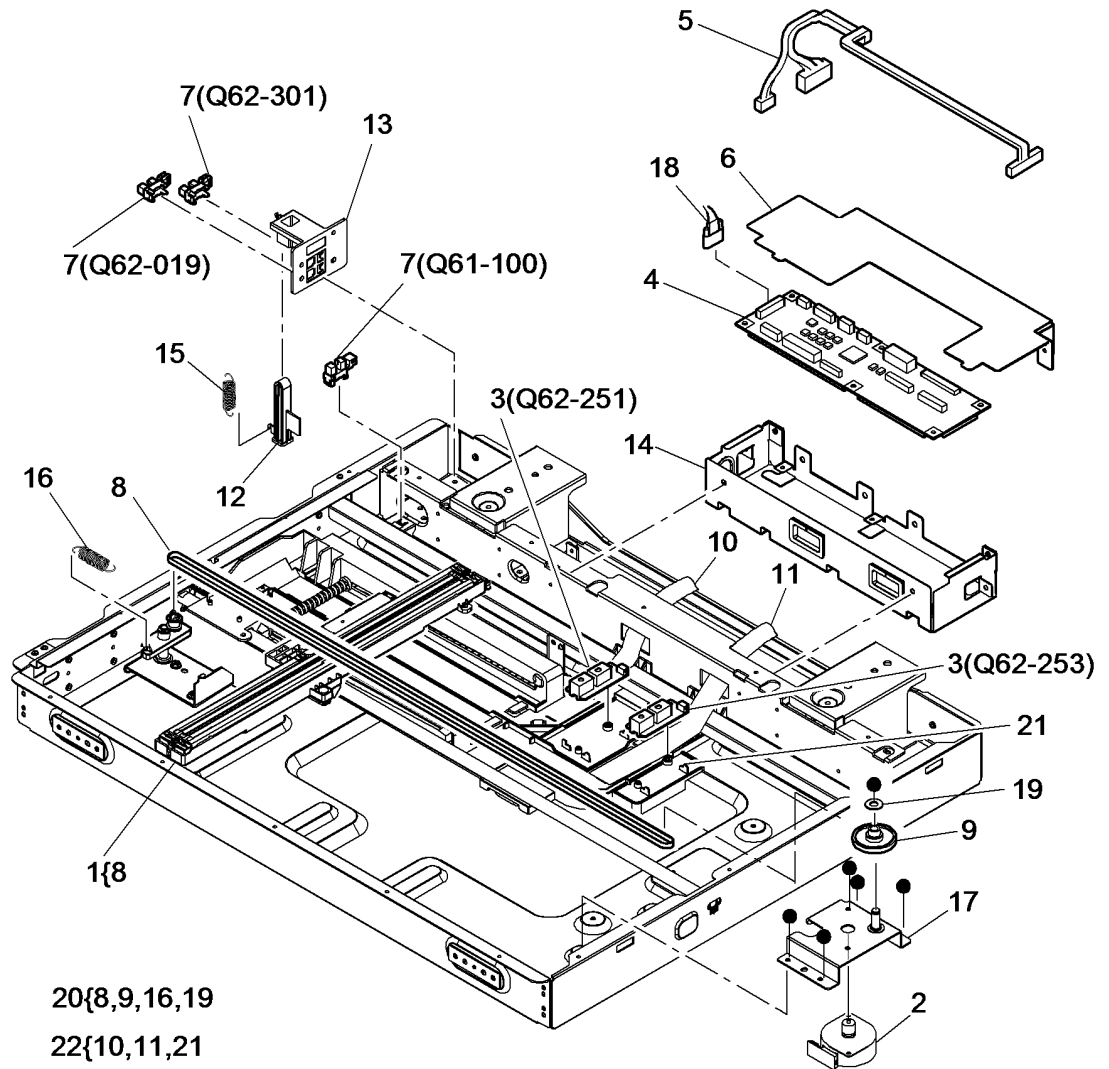
PL 60.20 Scanner Electrical Components

Item	Part	Description
1	-	Scan carriage assembly (REF: PL 60.25 Item 1) (REP 60.5)
2	927K06840	Scan carriage motor assembly (MOT62-031) (REP 60.9)
3	130E22840	Document size sensor 1 (Q62-251), Document size sensor 2 (Q62-253) (REP 60.11)
4	961K00080	Scanner PWB (REP 60.4)
5	-	SBC PWB/Scanner PWB comms/power harness (REF: PL 3.22 Item 13)
6	-	Faraday shield (Not Spared) (REP 60.1)
7	130E22820	Carriage home sensor (Q62-100)/DH angle sensor (Q62-301)/DH platen down sensor (Q62-019) (P/O PL 60.20 Item 13) (REP 60.8)
8	-	Scan carriage drive belt (P/O PL 60.20 Item 20) (REP 60.10)
9	-	Scan carriage drive pulley (P/O PL 60.20 Item 2) (REP 60.11)
10	117E50590	Scan carriage power ribbon cable (REP 60.7)
11	117E50580	Scan carriage data ribbon cable (REP 60.7)
12	-	SPDH angle sensor actuator (P/O PL 60.20 Item 13) (REP 60.8)
13	930K05880	Actuator support assembly (REP 60.8)
14	-	Scanner PWB support (Not Spared)
15	-	Actuator spring (P/O PL 60.20 Item 13)

16	-	Tension spring (Not Spared)
17	-	Mounting plate (P/O PL 60.20 Item 2)
18	117E50600	SBC PWB/Scanner PWB data cable (REF: PL 3.22 Item 23)
19	-	Pulley flange (P/O PL 60.20 Item 2)
20	-	Scanner drive kit (Not Spared)
21	-	Scanner harness support (P/O PL 60.20 Item 22)
22	952K60500	Scanner FFC harness assembly

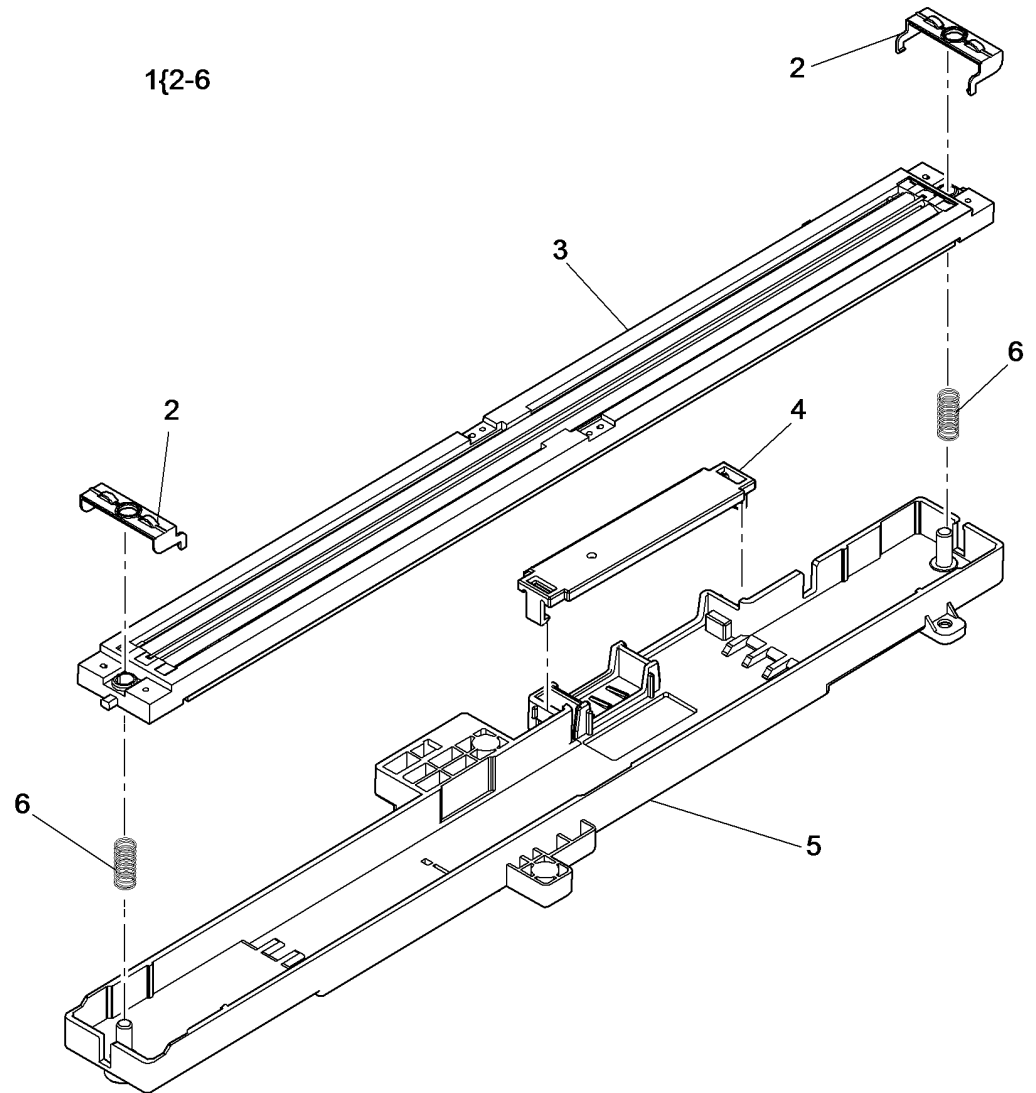
PL 60.25 Scan Carriage Assembly

Item	Part	Description
1	041K07020	Scan carriage assembly (REP 60.5)
2	-	Retaining clip (P/O PL 60.25 Item 1)
3	-	Scanner assembly (P/O PL 60.25 Item 1)
4	-	Ribbon cable retainer (P/O PL 60.25 Item 1)
5	-	Scan carriage base (P/O PL 60.25 Item 1)
6	-	Spring (P/O PL 60.25 Item 1)

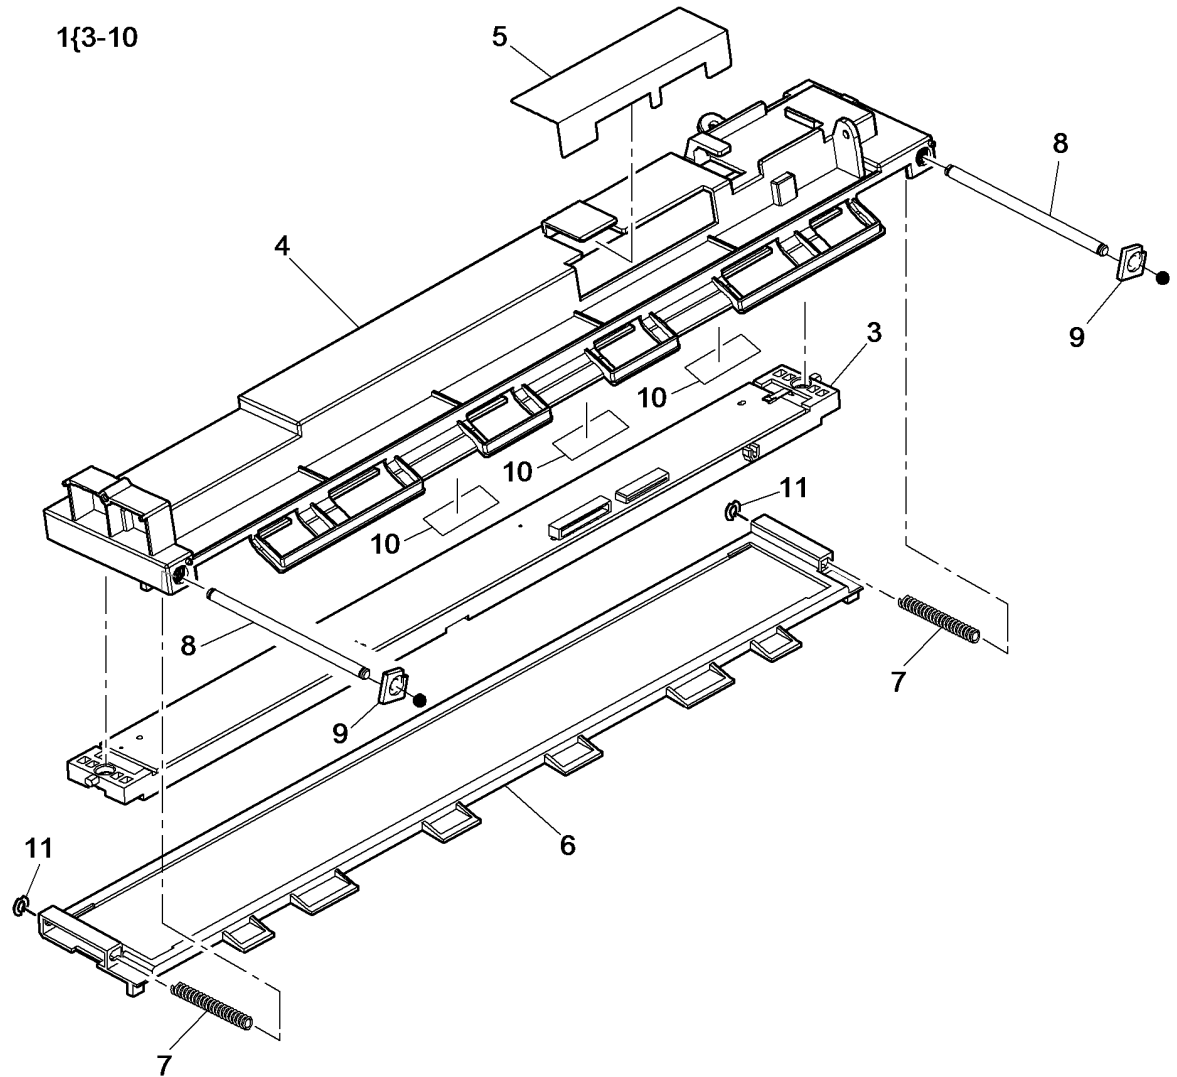
PL 60.30 Side 2 Scan Assembly

Item	Part	Description
1	801K77730	Side 2 scan assembly (REP 60.6)
2	-	Not used
3	-	Side 2 scanner assembly (P/O PL 60.30 Item 1)
4	-	Scan carriage unit (P/O PL 60.30 Item 1)
5	-	Ribbon cable shield (P/O PL 60.30 Item 1)
6	-	Lower cover and glass assembly (P/O PL 60.30 Item 1)
7	-	Spring (P/O PL 60.30 Item 1)
8	-	Shaft (P/O PL 60.30 Item 1)
9	-	Front retaining clip (P/O PL 60.30 Item 1)
10	-	Mylar (P/O PL 60.30 Item 1)
11	-	Rear retaining clip (P/O PL 60.30 Item 1)

NOTE: Refer to ADJ 60.2 for the side 2 scan assembly cleaning procedure.

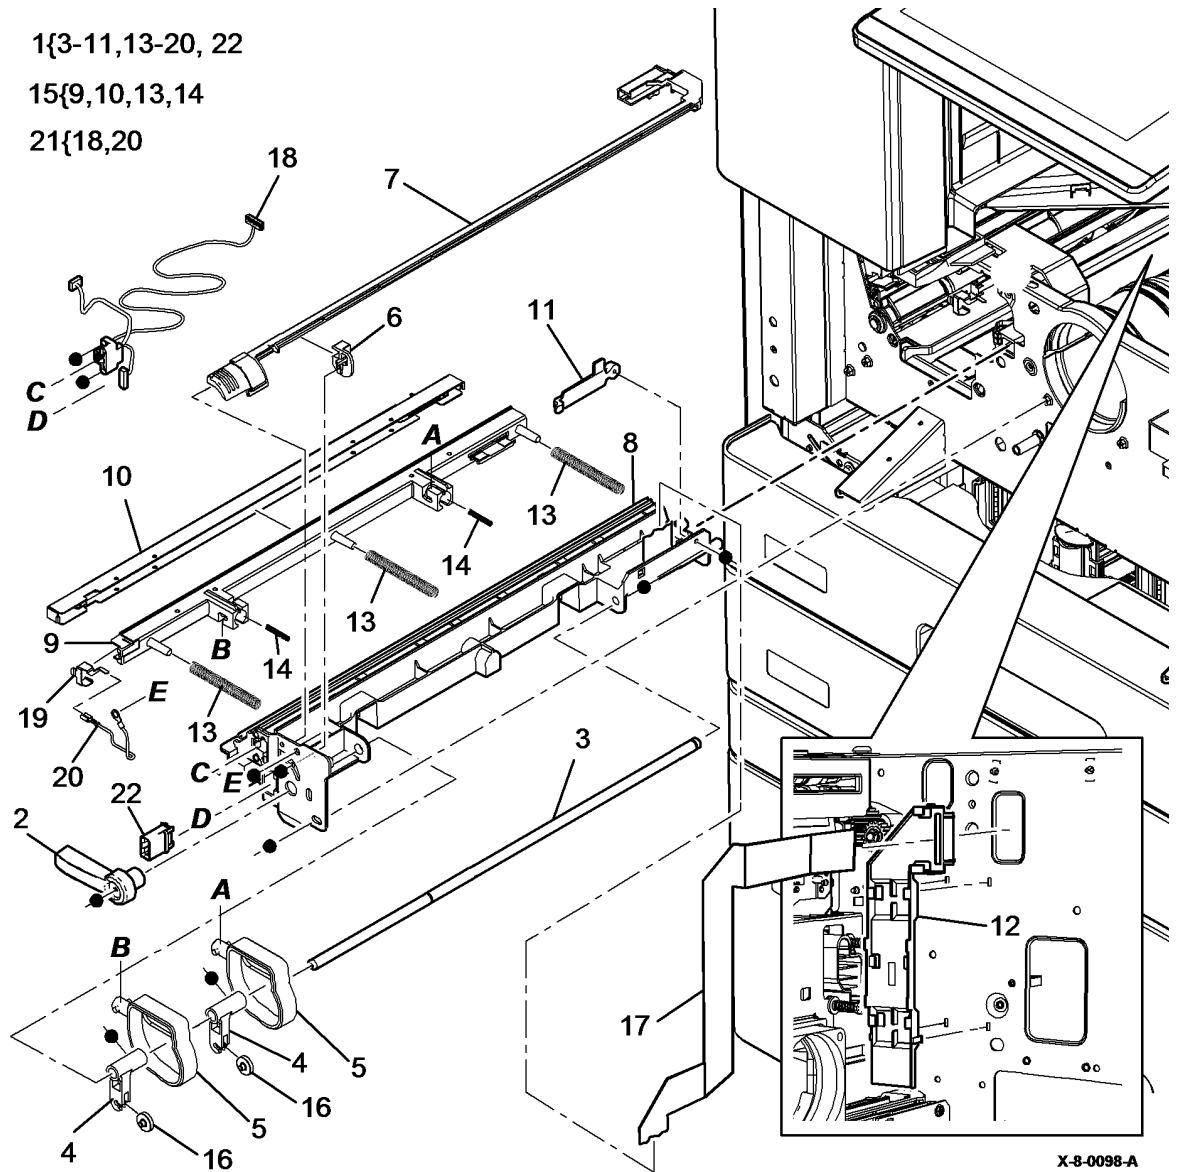
PL 60.35 LED Print Head Module

Item	Part	Description
1	008K02579	LED print head module (REP 60.12)
2	011E30932	Latch
3	-	Cam shaft (P/O PL 60.35 Item 1)
4	-	Cam (P/O PL 60.35 Item 1)
5	-	Cam cover (P/O PL 60.35 Item 1)
6	-	Locking bracket (P/O PL 60.35 Item 1)
7	-	LED print head cleaner (P/O PL 60.35 Item 1)
8	-	Housing (P/O PL 60.35 Item 1)
9	-	LED carrier (P/O PL 60.35 Item 1)
10	-	LED print head (P/O PL 60.35 Item 1)
11	-	Cable clamp (P/O PL 60.35 Item 1)
12	-	Ribbon cable support (Not Spared)
13	-	LED spring (P/O PL 60.35 Item 1)
14	-	Cam spring (P/O PL 60.35 Item 1)
15	-	LED print head assembly (P/O PL 60.35 Item 1) (REP 60.12)
16	-	Cam roller (P/O PL 60.35 Item 1)
17	-	LED print head module to SBC PWB ribbon cable (P/O PL 60.35 Item 1)
18	-	CRUM connectors assembly (P/O PL 60.35 Item 21) (REP 60.12)
19	-	Retaining clip (P/O PL 60.35 Item 1)
20	-	Grounding cable (P/O PL 60.35 Item 21)
21	952K37725	LED print head harness set
22	-	Connector (P/O PL 60.35 Item 1)

NOTE: Refer to ADJ 60.4 for cleaning the LED print head.

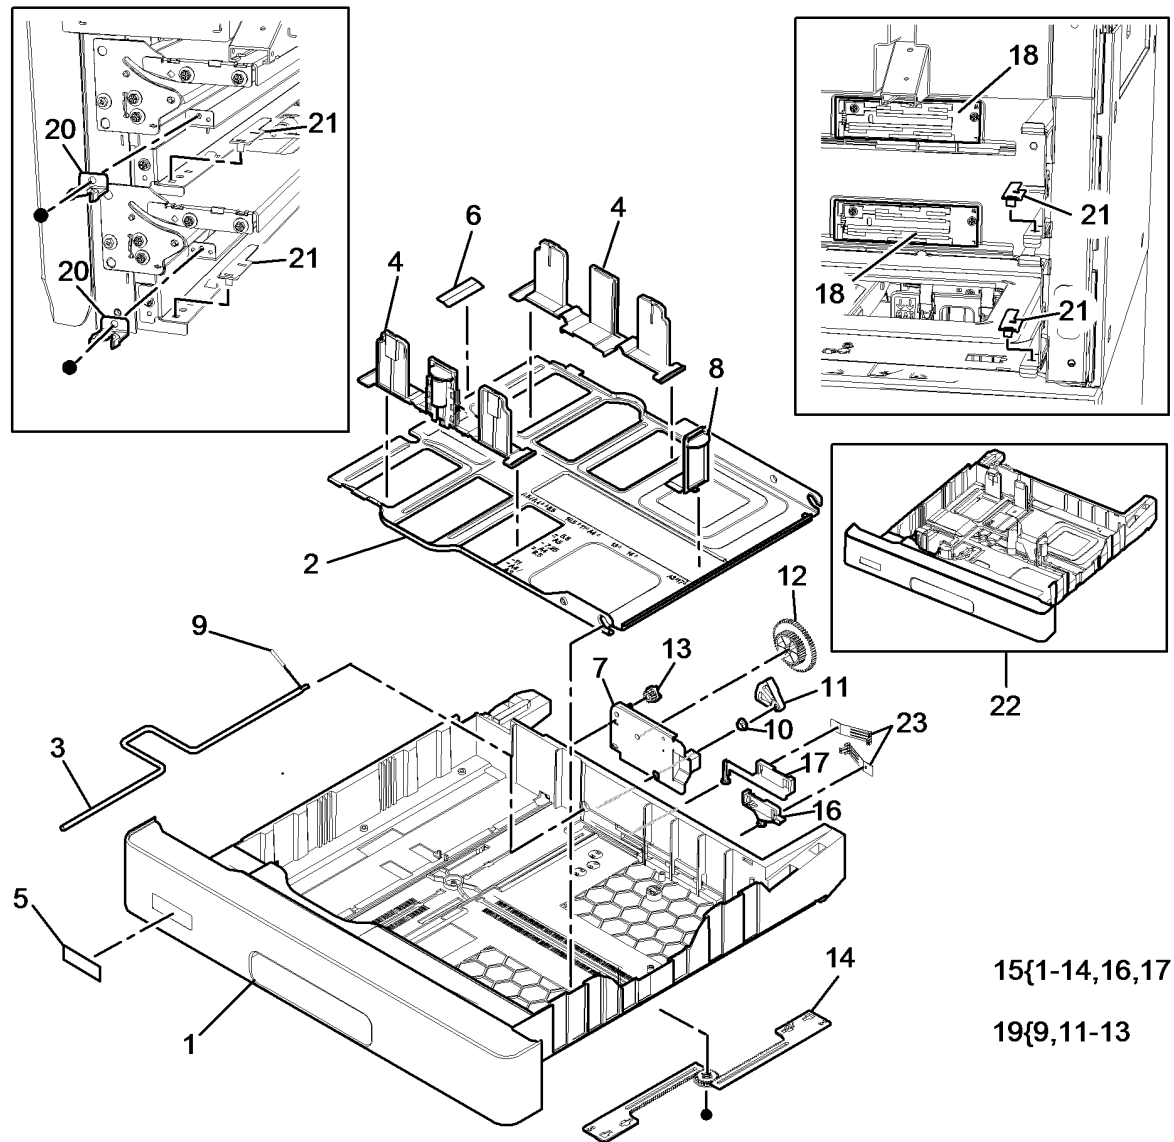
PL 70.10 Tray 1 and 2 Assembly

Item	Part	Description
1	-	Tray housing (P/O PL 70.10 Item 15)
2	-	Lift plate (P/O PL 70.10 Item 15)
3	-	Lift arm (P/O PL 70.10 Item 15)
4	-	Paper width guide (P/O PL 70.10 Item 15) (REP 70.3)
5	-	Label (P/O PL 70.10 Item 15)
6	-	Pad (P/O PL 70.10 Item 15)
7	-	Retaining plate (P/O PL 70.10 Item 15) (REP 70.12)
8	-	Paper length guide (P/O PL 70.10 Item 15) (REP 70.3)
9	-	Dowel pin (P/O PL 70.10 Item 19) (REP 70.12)
10	-	Bearing (P/O PL 70.10 Item 15) (REP 70.12)
11	-	Quadrant gear (60T) (P/O PL 70.10 Item 19) (REP 70.12)
12	-	Gear (60T) (P/O PL 70.10 Item 19) (REP 70.12)
13	-	Gear (13T) (P/O PL 70.10 Item 19) (REP 70.12)
14	-	Rack assembly (P/O PL 70.10 Item 15)
15	850K04110	Tray assembly (REP 70.1, ADJ 40.1)
16	-	Length sensor bracket assembly (P/O PL 70.10 Item 15)
17	-	Width sensor bracket assembly (P/O PL 70.10 Item 15)
18	960K79745	Paper size sensing PWB (REP 70.4)
19	859K04220	Lift gear kit (REP 70.12)
20	819E15872	Tray clip

21	819E20350	Slide pad
22	-	Envelope tray assembly (P/O PL 31.12 Item 9)
23	869E35810	Paper size leaf spring

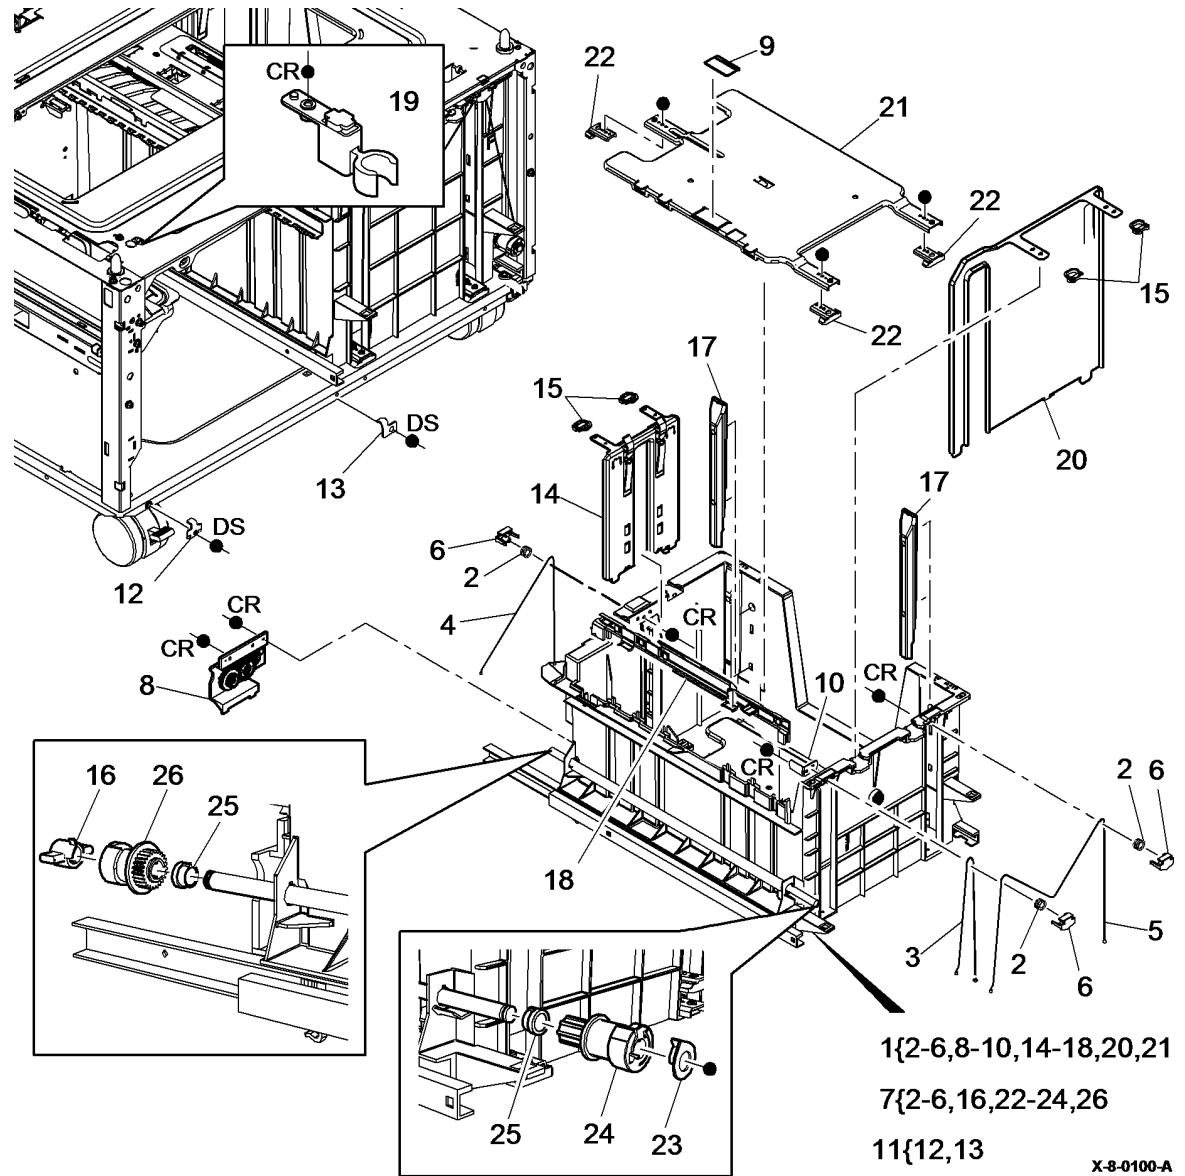
Item	Part	Description
1	050K77271	Tray 3 assembly (REP 70.5)
2	-	Tray hoist pulley (P/O PL 70.18 Item 7)
3	-	Front short elevator cable (P/O PL 70.18 Item 7)
4	-	Rear elevator cable (P/O PL 70.18 Item 7)
5	-	Front long elevator cable (P/O PL 70.18 Item 7)
6	-	Pulley carrier (P/O PL 70.18 Item 7)
7	604K84091	Tray 3 elevator cable kit (REP 70.8)
8	004K07860	Tray 3 elevate damper assembly (REP 70.11)
9	-	Retard pad (Not Spared)
10	-	Tray 3 skew bracket (P/O PL 31.14 Item 4)
11	604K83671	Tray 3 and 4 clamp kit
12	-	Side clamp (2 off) (P/O PL 70.18 Item 11)
13	-	Centre clamp (P/O PL 70.18 Item 11)
14	-	Rear paper guide (P/O PL 70.18 Item 1) (ADJ 70.1)
15	819E27770	Retaining clips
16	-	Elevator drives gear coupling (P/O PL 70.18 Item 7)
17	-	Tray 3 paper guide (P/O PL 70.18 Item 1)
18	815E92301	Separation strip
19	819E20420	Front clip (ADJ 80.5)
20	-	Front paper guide (P/O PL 70.18 Item 1) (ADJ 70.1)
21	-	Lift plate (P/O PL 70.18 Item 1)

22	-	Guide plate (P/O PL 70.18 Item 7)
23	-	Spacer (P/O PL 70.18 Item 7)
24	-	Elevator pulley (P/O PL 70.18 Item 7)
25	-	Bearing (P/O PL 70.18 Item 1)
26	-	Elevator gear (P/O PL 70.18 Item 7)

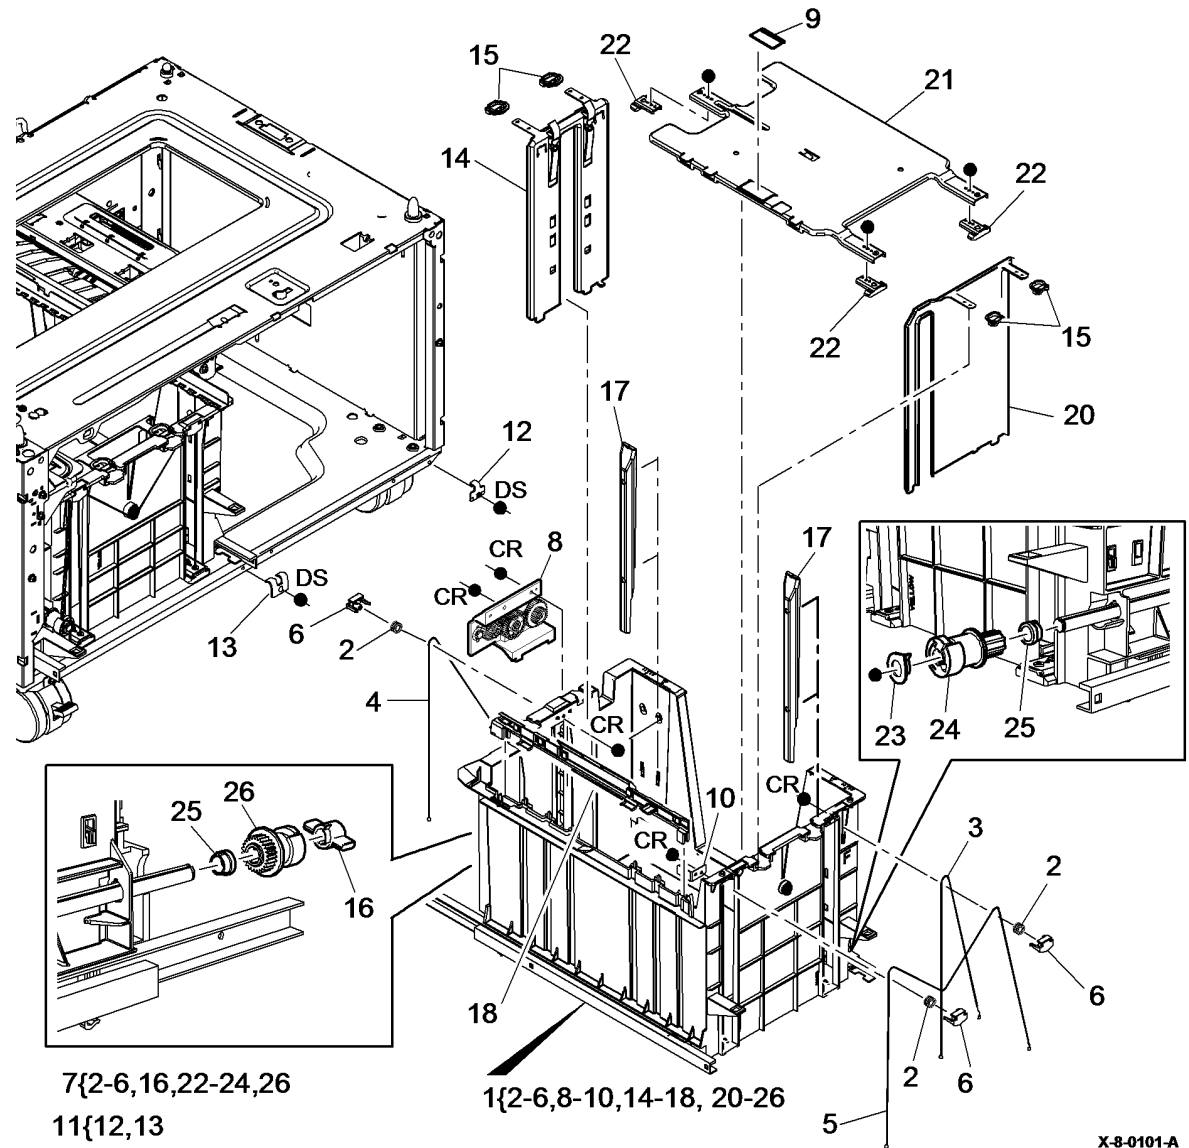
PL 70.19 Tray 4 Assembly

Item	Part	Description
1	050K74923	Tray 4 assembly (REP 70.13)
2	-	Tray hoist pulley (P/O PL 70.19 Item 7)
3	-	Front short elevator cable (P/O PL 70.19 Item 7)
4	-	Rear elevator cable (P/O PL 70.19 Item 7)
5	-	Front long elevator cable (P/O PL 70.19 Item 7)
6	-	Pulley carrier (P/O PL 70.19 Item 7)
7	604K84081	Tray 4 elevator cable kit (REP 70.8)
8	004K07870	Tray 4 elevate damper assembly (REP 70.11)
9	-	Retard pad (Not Spared)
10	-	Tray 4 skew bracket (P/O PL 31.14 Item 4)
11	604K83671	Tray 3 and 4 clamp kit
12	-	Side clamp (2 off) (P/O PL 70.19 Item 11)
13	-	Centre clamp (P/O PL 70.19 Item 11)
14	-	Rear paper guide (P/O PL 70.19 Item 1) (ADJ 70.1)
15	819E27770	Retaining clips
16	-	Elevator drives gear coupling (P/O PL 70.19 Item 7)
17	-	Tray 4 paper guide (P/O PL 70.19 Item 1)
18	815E92301	Separation strip
19	-	Not used
20	-	Front paper guide (P/O PL 70.19 Item 1) (ADJ 70.1)
21	-	Lift plate (P/O PL 70.19 Item 1)

22	-	Guide plate (P/O PL 70.19 Item 7)
23	-	Spacer (P/O PL 70.19 Item 7)
24	-	Elevator pulley (P/O PL 70.19 Item 7)
25	-	Bearing (Not Spared)
26	-	Elevator gear (P/O PL 70.19 Item 7)

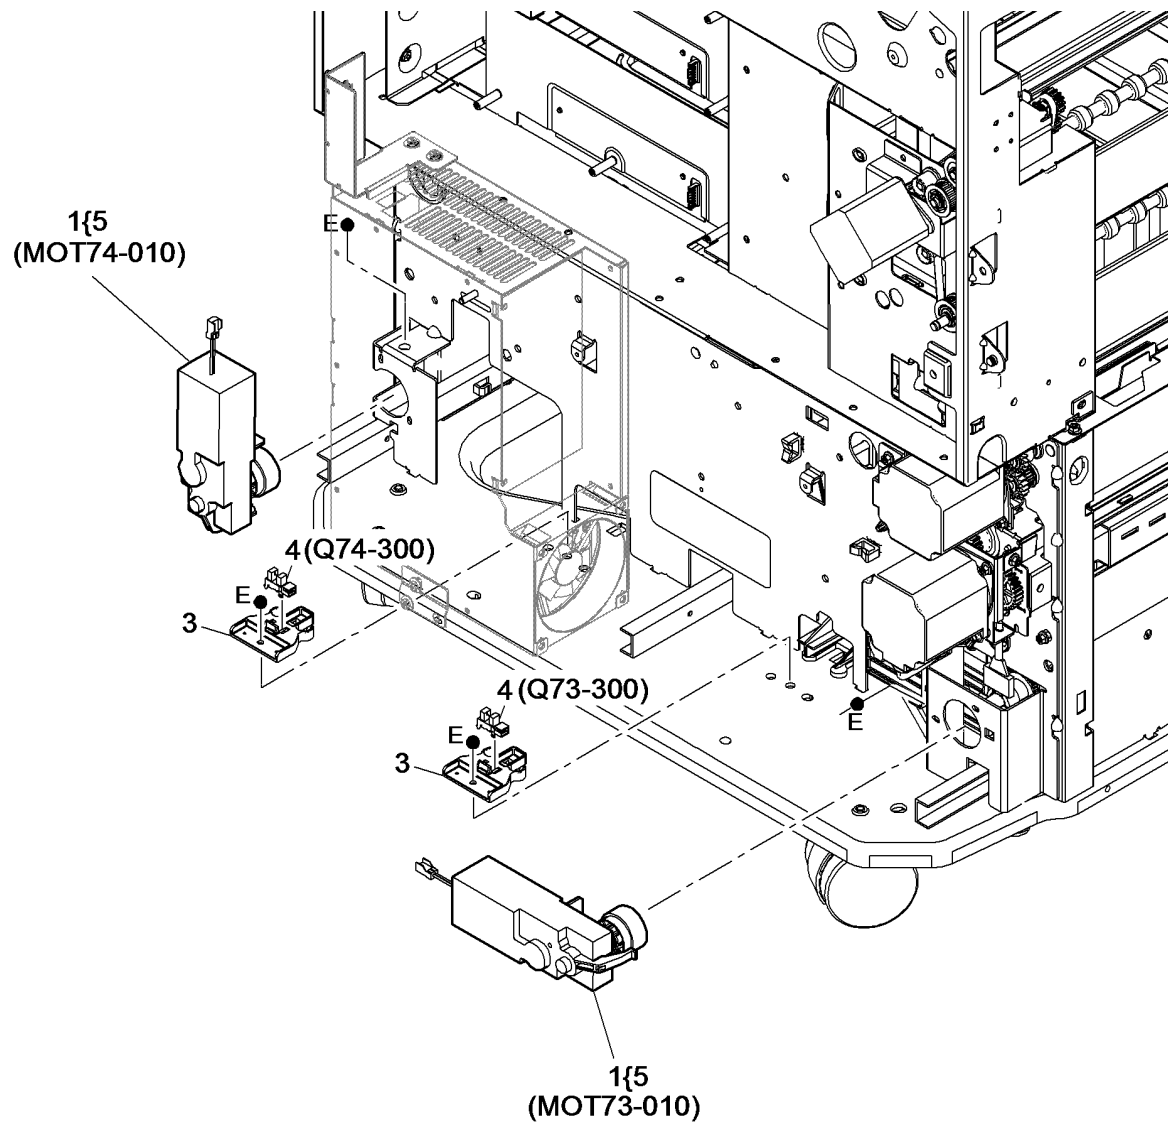
PL 70.21 Elevator Motor and Control PWB

Item	Part	Description
1	127K78351	Tray 3 elevator motor (MOT73-010) (REP 70.6)/ Tray 4 elevator motor (MOT74-010)(W/O TAG 030) (REP 70.14)
-	-	Tray 4 elevator motor (MOT74-010) (W/TAG 030)(P/O PL 31.12 Item 24)
2	-	Not used
3	819E21570	Sensor holder
4	-	Tray 3 home sensor (Q73-300)/ Tray 4 home sensor (Q74-300) (REP 70.10)

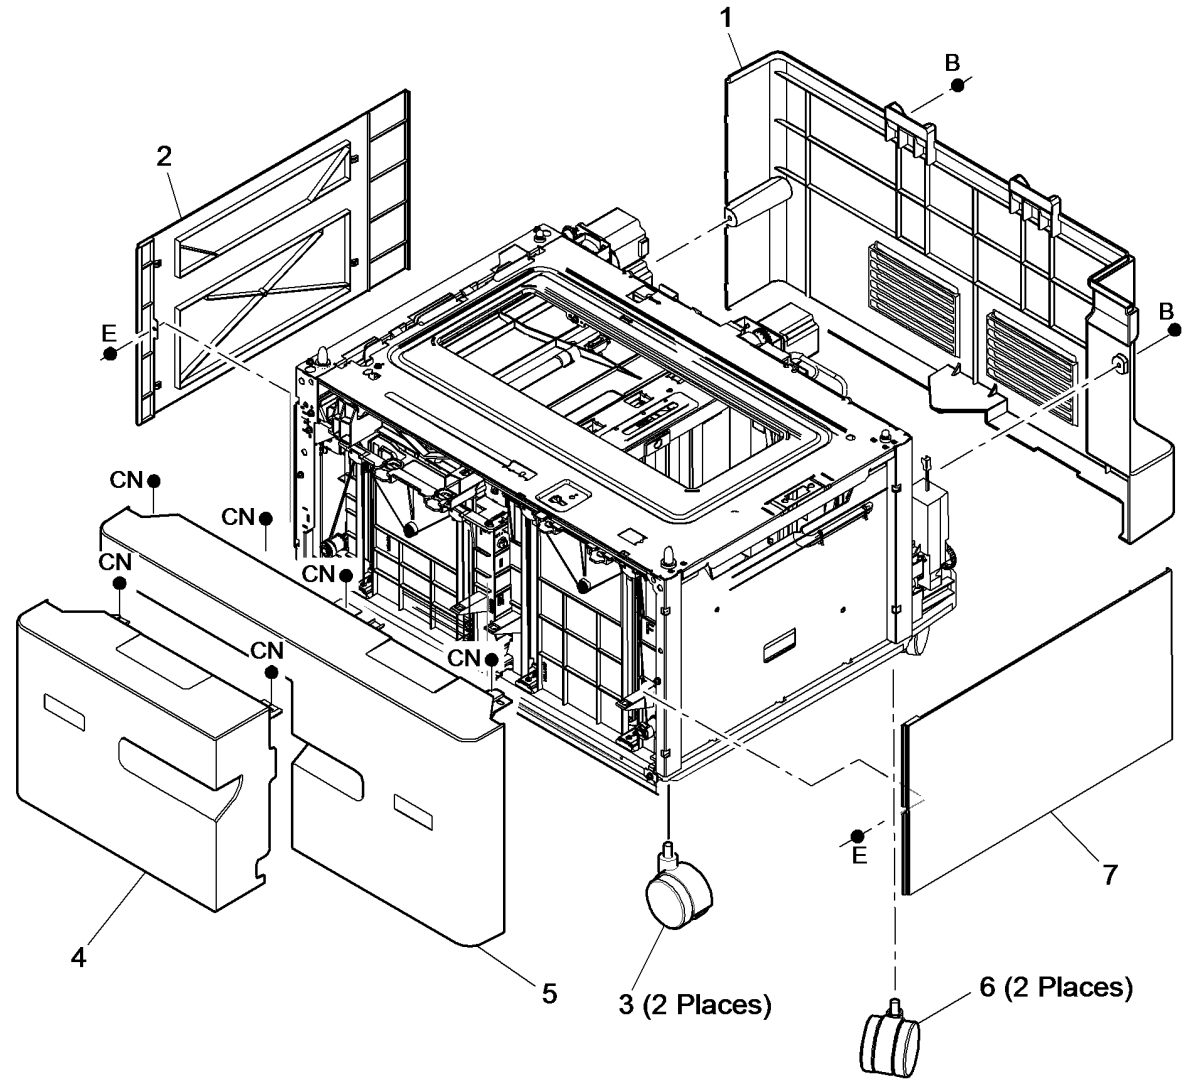
PL 70.26 Tray 3 and 4 Assembly Covers

Item	Part	Description
1	822E50368	Lower rear cover
2	822E53824	Left cover
3	859K03060	Castor (locking)
4	822E68940	Tray 3 front cover (REP 70.5)
5	822E68950	Tray 4 front cover
6	-	Castor (Not Spared)
7	822E15371	Right cover

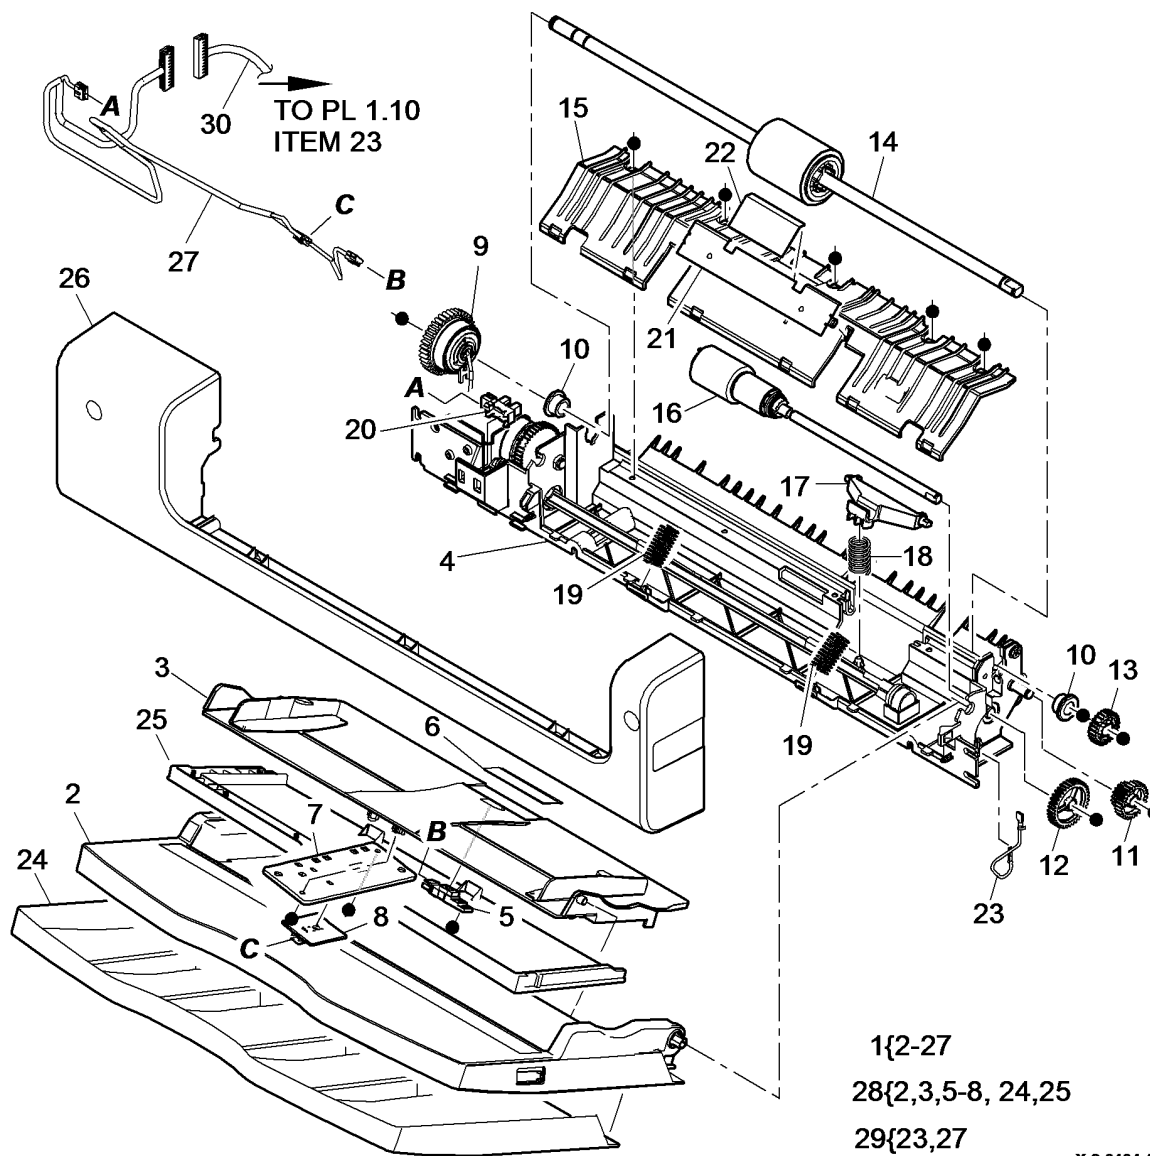
PL 70.35 Bypass Tray Assembly (Tray 5)

Item	Part	Description
1	850K04130	Bypass tray assembly (REP 70.2)
2	-	Upper tray assembly (P/O PL 70.35 Item 28)
3	-	Paper tray guide assembly (P/O PL 70.35 Item 28)
4	-	Feeder frame (P/O PL 70.35 Item 1)
5	-	Bypass tray empty sensor (Q75-320) (P/O PL 70.35 Item 28)
6	019K20200	Retard pad (See NOTE)
7	-	Bracket (P/O PL 70.35 Item 28)
8	-	Bypass tray width sensor (Q74-350) (P/O PL 70.35 Item 28) (REP 70.7)
9	007K20755	Bypass tray clutch (CL75-325) (REP 80.15)
10	-	Bearing (P/O PL 70.35 Item 1)
11	-	Idler gear (P/O PL 70.35 Item 1)
12	-	Retard shaft gear (P/O PL 70.35 Item 1)
13	-	Feed shaft gear (P/O PL 70.35 Item 1)
14	006K34444	Feed roll assembly (See NOTE) (REP 80.15)
15	-	Baffle (P/O PL 70.35 Item 1)
16	006K34432	Retard roll assembly (See NOTE) (REP 80.16)
17	-	Retainer (P/O PL 70.35 Item 1)
18	-	Nip spring (P/O PL 70.35 Item 1)
19	-	Elevator tray spring (P/O PL 70.35 Item 1)
20	-	Bypass tray elevate sensor (Q75-040)

21	-	Paper guide (P/O PL 70.35 Item 1)
22	801E35571	Mylar retard shield (REP 80.34, ADJ 80.4)
23	-	Grounding cable (P/O PL 70.35 Item 29)
24	-	Lower tray (P/O PL 70.35 Item 28)
25	-	Sensor cover (P/O PL 70.35 Item 28)
26	-	Bypass tray feedhead cover (P/O PL 70.35 Item 1)
27	-	Bypass tray harness (P/O PL 70.35 Item 27) (REP 70.17)
28	050K77187	Bypass elevate tray assembly (REP 70.17)
29	952K37733	Bypass tray harness set
30	-	IOT PWB to Bypass tray intermediate harness (P/O PL 80.10 Item 14) (REP 80.33)

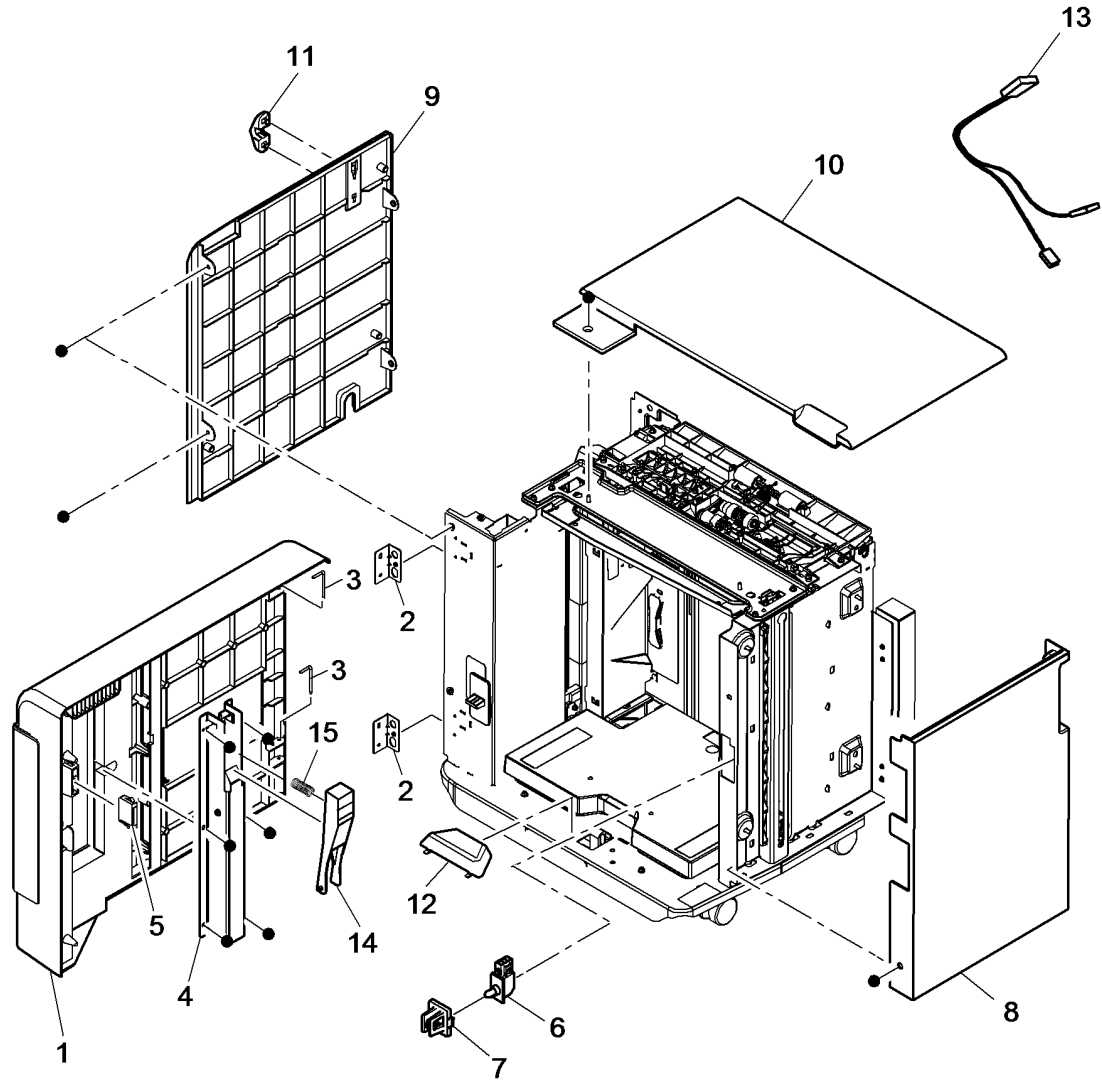
PL 75.60 Tray 6 Covers

Item	Part	Description
1	948K22269	Front door assembly
2	-	Front door hinge (P/O PL 75.60 Item 1)
3	-	Front door hinge pin (P/O PL 75.60 Item 1)
4	-	Trail edge guide assembly (P/O PL 75.60 Item 1)
5	-	Latch magnet (P/O PL 75.60 Item 1)
6	110E22080	Interlock switch (S76-300)
7	-	Interlock switch adapter (Not Spared)
8	948K33410	Front cover (REP 70.25)
9	822E50474	Rear cover (REP 70.25)
10	822E50464	Top cover (REP 70.25)
11	-	Cable clamp (P/O PL 75.60 Item 9)
12	848E05863	Bias knuckle cover
13	952K63180	Front door interlock harness (PJ507)
14	-	Tamper guide lever (P/O PL 75.60 Item 1)
15	-	Tamper lever compression spring (P/O PL 75.60 Item 1)

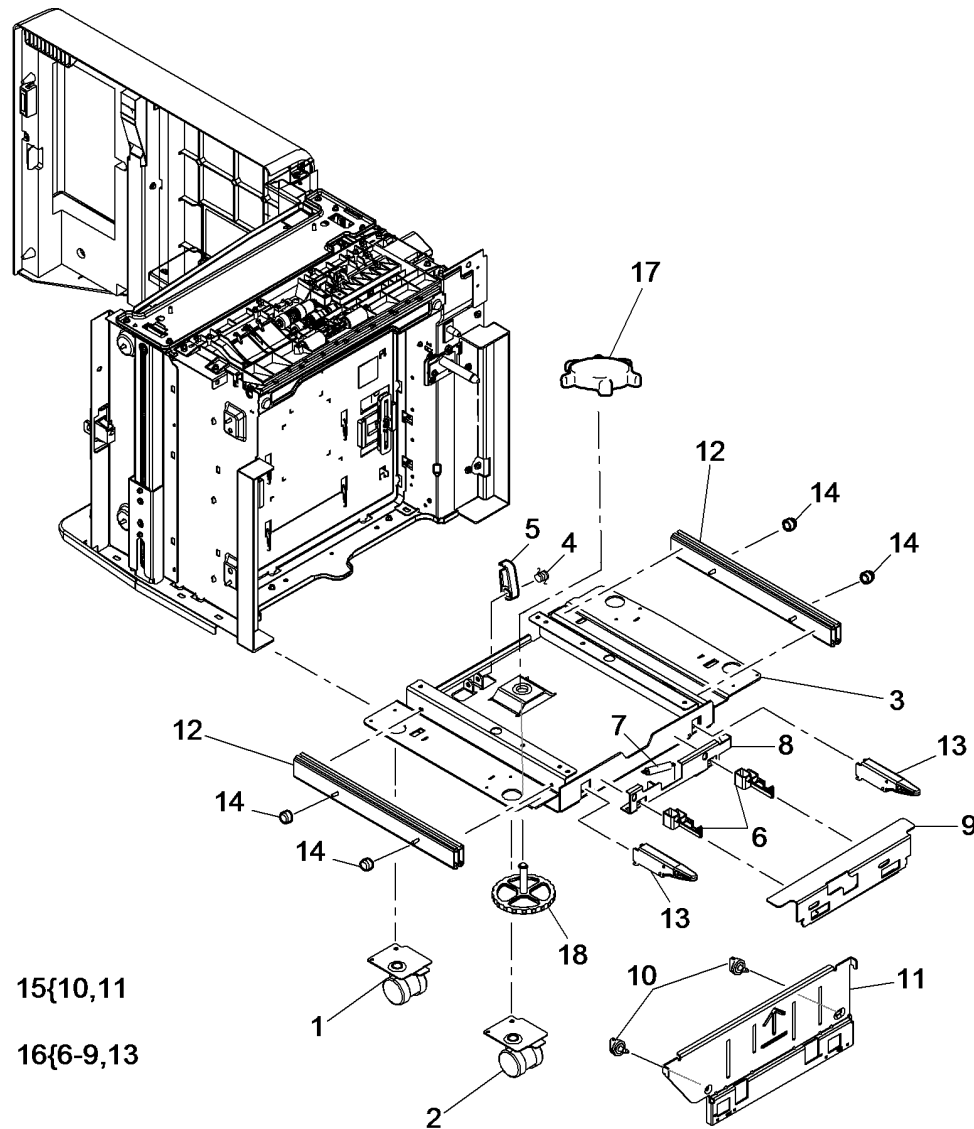
PL 75.62 Tray 6 Base

Item	Part	Description
1	-	Adjustable caster (Not spared)
2	-	Caster (Not Spared)
3	-	Platform assembly (Not Spared)
4	009E74211	Spring bias
5	003E76870	Latch bias
6	003E78020	Docking latch (REP 70.26)
7	-	Docking latch spring (P/O PL 75.62 Item 16)
8	-	Docking latch bracket (P/O PL 75.62 Item 16)
9	-	Docking latch main bracket (P/O PL 75.62 Item 16)
10	803E13680	Docking latch thumb screw
11	-	Docking plate (Not Spared)
12	-	Slide assembly (Not Spared)
13	-	Docking guides (P/O PL 75.62 Item 16)
14	-	Slide assembly locking nut (Not Spared)
15	049K49841	Docking bracket assembly
16	003K20681	Latch assembly
17	-	Adjuster wheel (Not Spared) (ADJ 70.3)
18	-	Adjuster wheel base (Not Spared)

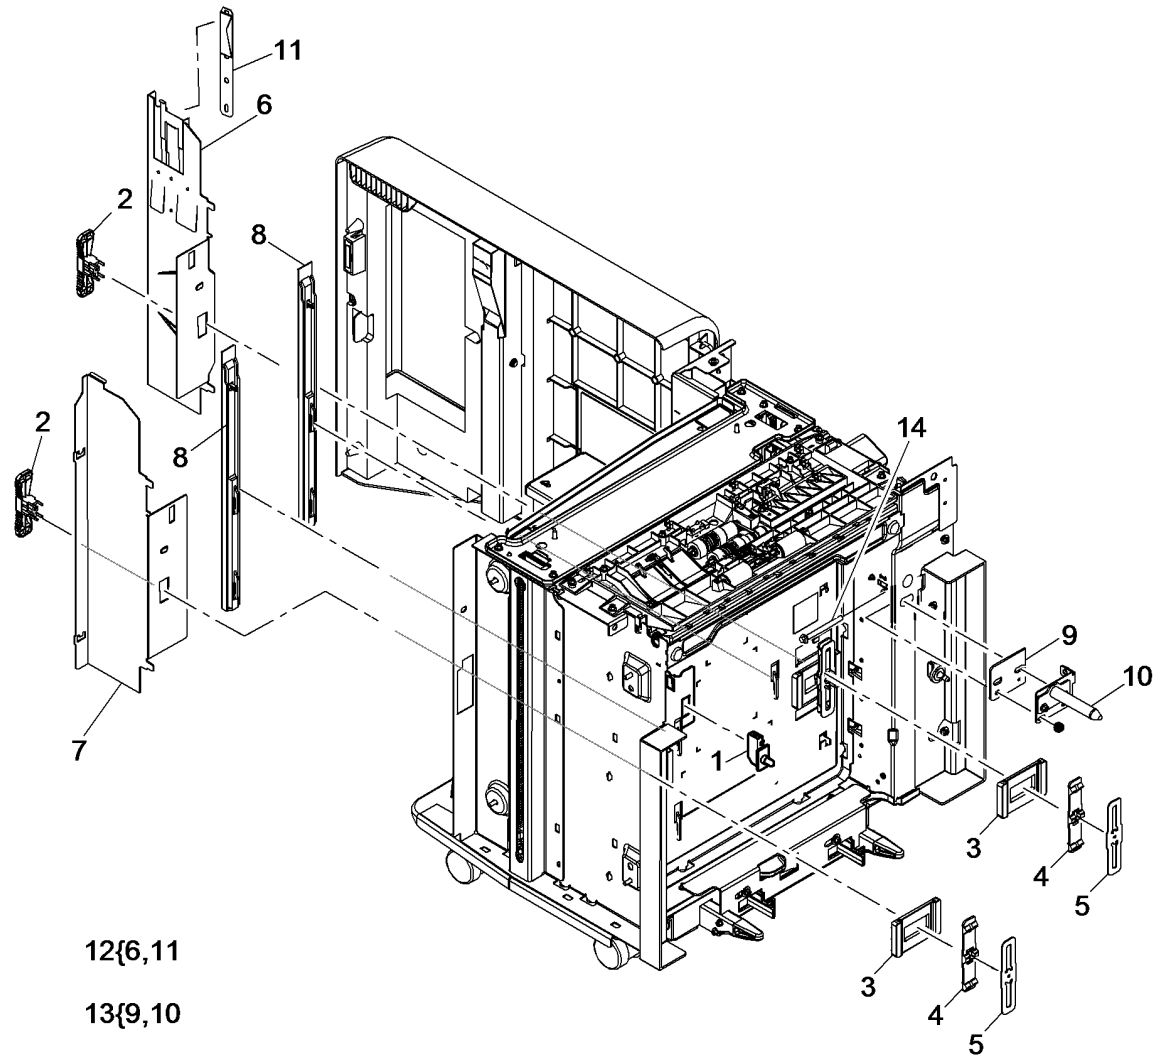
PL 75.64 Tray 6 Guides

Item	Part	Description
1	110K21080	Tray 6 docking interlock switch (S76-310)
2	-	Handle latch (Not Spared)
3	-	Latch spacer (Not Spared)
4	-	Slide latch (Not Spared)
5	-	Spring leaf (Not Spared)
6	-	Rear guide (P/O PL 75.64 Item 12) (ADJ 70.2)
7	-	Front guide assembly (Not Spared) (ADJ 70.2)
8	038E53361	Guide strip
9	-	Adjustment plate (Not Spared)
10	-	Interlock guide (Not Spared)
11	-	Rear guide assembly spring (P/O PL 75.64 Item 12)
12	038K25780	Rear guide assembly
13	029K05000	Docking pin assembly
14	-	Securing bolt (Not Spared)

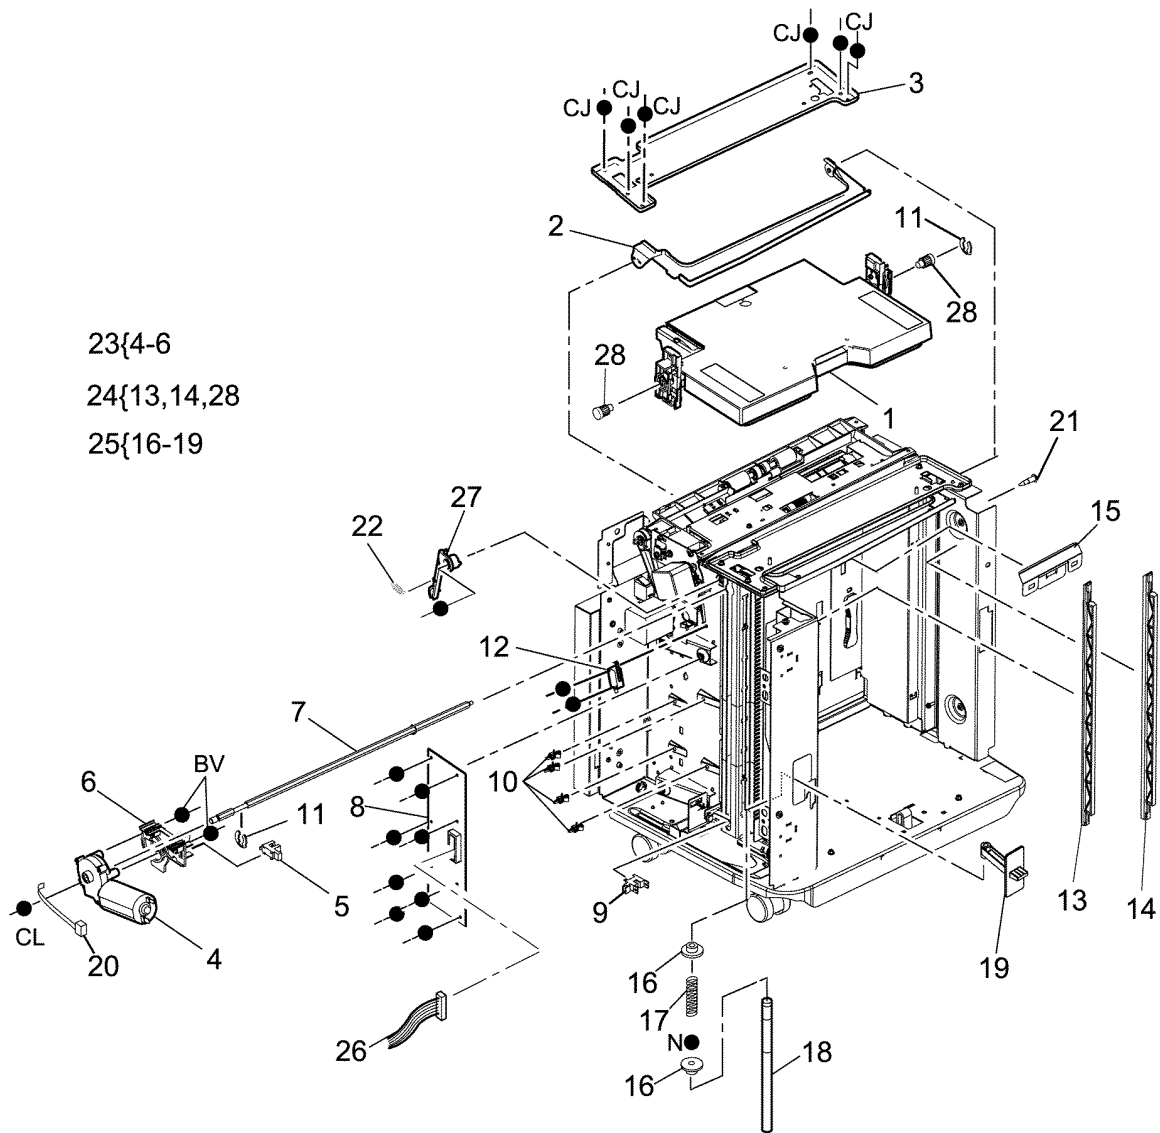
PL 75.68 Tray 6 Lift Assembly (1 of 2)

Item	Part	Description
1	-	Tray assembly (complete) (Not Spared)
2	-	Crash bar (Not Spared)
3	-	Frame top brace (Not Spared)
4	-	Elevator motor (MOT76-010) (P/O PL 75.68 Item 23)
5	930K01410	Elevator encoder sensor (Q76-340)
6	869E49121	Elevator motor bracket
7	-	Elevator motor shaft (Not Spared)
8	961K03670	Tray 6 Control PWB
9	130K75511	Tray down sensor (Q76-335) (REP 70.20)
10	-	Standoff (Not Spared)
11	-	Tray level drive gear clip (Not Spared)
12	110E06961	Upper limit switch (S75-412) (REP 70.22)
13	-	Rear elevator rack (P/O PL 75.68 Item 24)
14	-	Front elevator rack (P/O PL 75.68 Item 24)
15	-	Retard roller shield (Not Spared)
16	-	Shipping pin bearing (Not Spared)
17	-	Shipping pin spring (Not Spared)
18	-	Shipping pin (Not Spared)
19	-	Shipping pin handle (Not Spared)
20	-	Cable tie (Not Spared)
21	-	Clinch stud (Not Spared)
22	-	Actuator spring (Not Spared)
23	927K05801	Elevator motor assembly (REP 70.21)

24	007K25090	Elevator rack assembly (REP 70.27)
25	003K20950	Shipping pin handle assembly
26	-	Media path driver PWB to Tray 6 PWB harness (Not Spared) (PJ502, PJ513)
27	-	Upper limit switch actuator (Not Spared)
28	-	Tray level drive gear (P/O PL 75.68 Item 24)
