708P91368
September 2017

Xerox® AltaLink® B8090 Family Multifunction Printer Service Manual

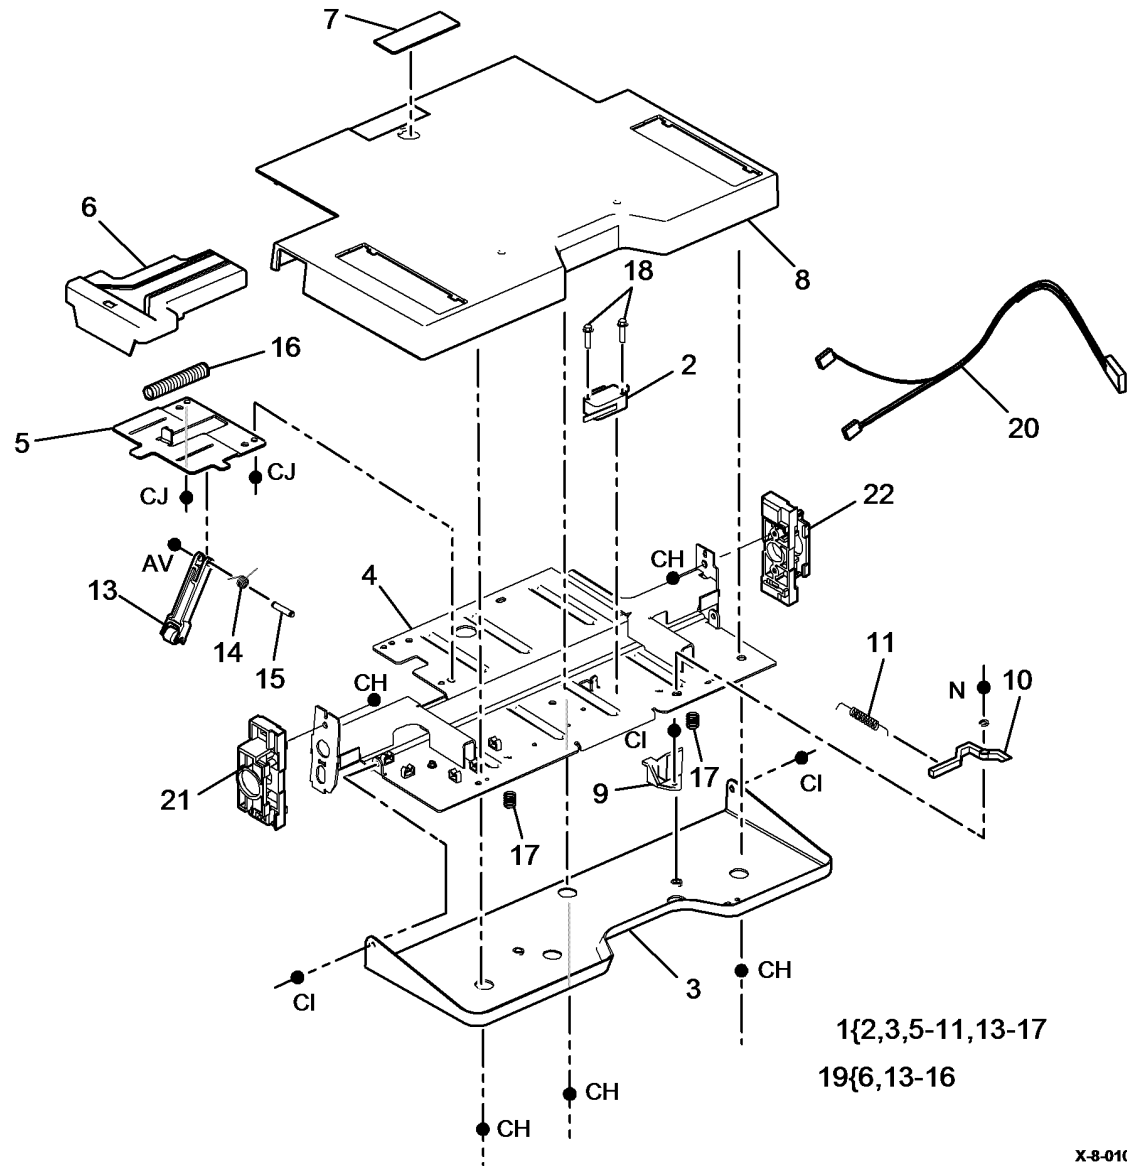
PL 75.70 Tray 6 Lift Assembly (2 of 2)

Item	Part	Description
1	-	Tray lift assembly (Not Spared)
2	110E06961	Tray down limit switch (S75-415) (REP 70.23)
3	-	Lower safety bar (P/O PL 75.70 Item 1)
4	-	Lift plate (Not Spared)
5	-	Fixing plate (Not Spared)
6	-	Infill plate (P/O PL 75.70 Item 19)
7	019K13470	Cork pad
8	-	Tray lift top cover (P/O PL 75.70 Item 1)
9	-	Lift plate crash bar actuator 2 (P/O PL 75.70 Item 1)
10	-	Lift plate crash bar actuator 1 (P/O PL 75.70 Item 1)
11	-	Crash bar actuator spring (P/O PL 75.70 Item 1)
12	-	Not used
13	-	Infill actuator arm (P/O PL 75.70 Item 19)
14	-	Infill actuator arm spring (P/O PL 75.70 Item 19)
15	-	Infill actuator arm pin (P/O PL 75.70 Item 19)
16	-	Infill plate spring (P/O PL 75.70 Item 19)
17	-	Lower safety spring (Not Spared)
18	612W25655	Tray down limit switch screw
19	815K11380	Infill plate assembly
20	962K50461	Tray 6 elevator harness (PJ504)
21	032E29800	Rear elevator tray guide (REP 70.28)

-	-	Rear elevator tray guide (P/O PL 31.12 Item 18)
22	032E29790	Front elevator tray guide (REP 70.28)
-	-	Front elevator tray guide (P/O PL 31.12 Item 18)

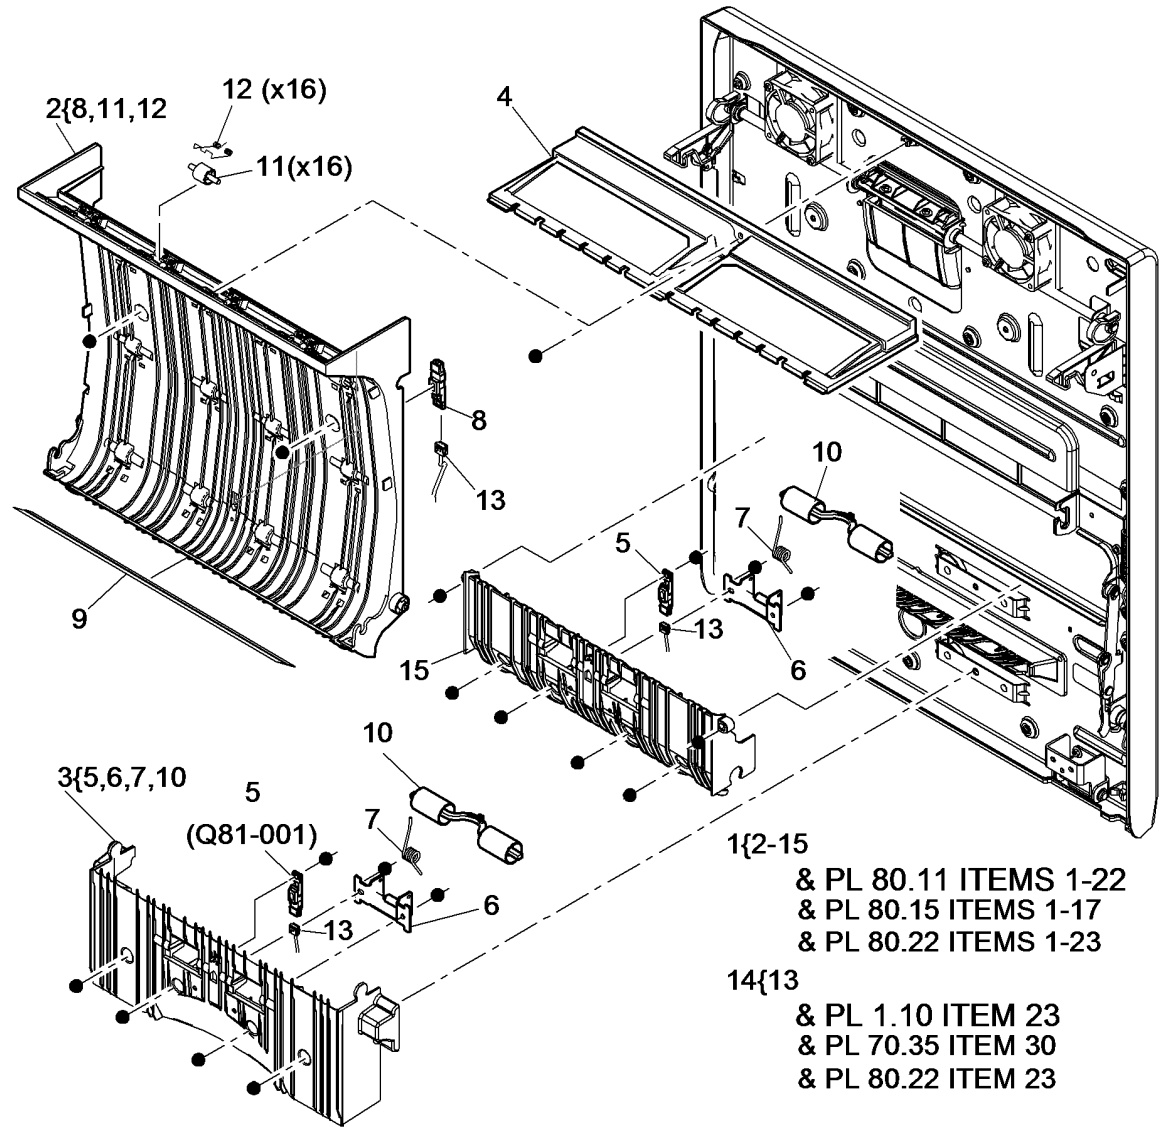
PL 80.10 Left Door Assembly (1 of 2)

-	-	Left door fan cover (P/O PL 80.10 Item 1) (65-90 ppm)
5	-	Tray 1 TAR sensor (Q81-001)/ Tray 2 TAR sensor (Q82-001) (P/O PL 80.10 Item 3) (REP 80.2)
6	-	Bracket (P/O PL 80.10 Item 3)
7	-	Tension spring (P/O PL 80.10 Item 3)
8	-	Duplex sensor (Q83-160) (P/O PL 80.10 Item 2) (REP 80.9)
9	-	Mylar (P/O PL 80.10 Item 2)
10	-	Nip roll assembly (P/O PL 80.10 Item 3)
11	-	Duplex roll idler (P/O PL 80.10 Item 2)
12	-	Idler spring (P/O PL 80.10 Item 2)
13	-	Left door sensor and fan harness (P/O PL 80.10 Item 14) (REP 80.33)
14	952K62160	Left door harness set (65-90 ppm) (REP 80.33)

-	952K62150	Left door harness set (45-55 ppm)
15	038K25800	Upper left door paper guide
16	-	Duplex guide assembly (Not Spared)

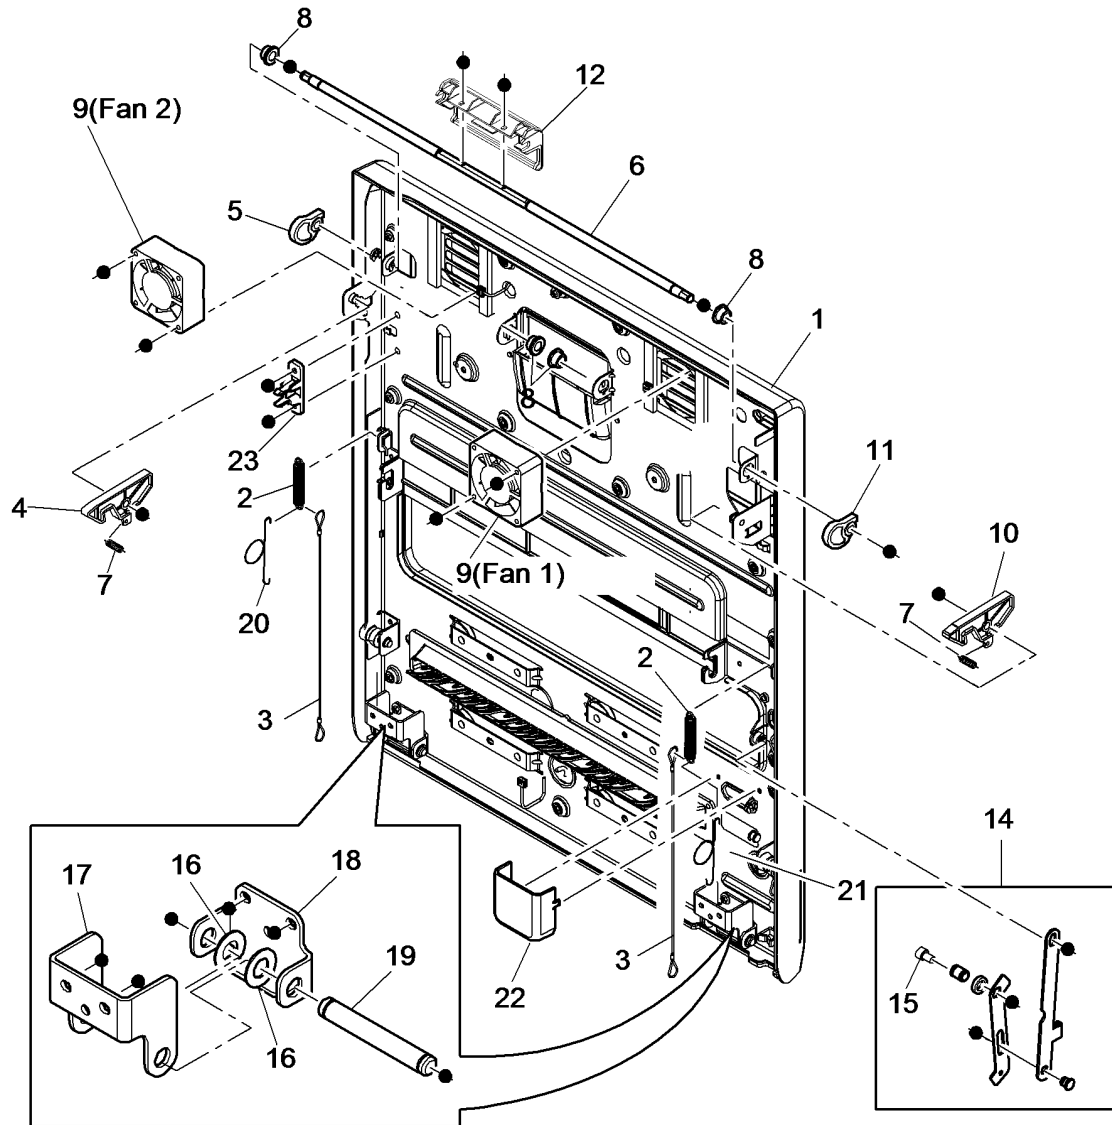
Item	Part	Description
1	-	Left door frame and cover assembly (P/O PL 80.10 Item 1) (REP 80.13)
2	-	Damper spring (P/O PL 31.14 Item 3)
3	-	Damper cable (P/O PL 31.14 Item 3)
4	-	Front latch (P/O PL 80.10 Item 1) (REP 80.11)
5	-	Front latch cam (P/O PL 80.10 Item 1)
6	-	Latch handle shaft (P/O PL 80.10 Item 1)
7	-	Latch spring (P/O PL 80.10 Item 1) (REP 80.11)
8	-	Bearing (P/O PL 80.10 Item 1)
9	127E17991	Left door fan 1 / Left door fan 2 (MOT80-015) (45-55 ppm) (REP 80.35)
10	-	Rear latch (P/O PL 80.10 Item 1) (REP 80.11)
11	-	Rear latch cam (P/O PL 80.10 Item 1)
12	-	Latch handle (P/O PL 80.10 Item 1)
13	-	Not used
14	-	Door link assembly (P/O PL 31.14 Item 3)
15	-	Door link locking screw (P/O PL 80.10 Item 1)
16	-	Plastic washer (P/O PL 80.10 Item 1)
17	-	Hinge support bracket (P/O PL 80.10 Item 1)
18	-	Hinge bracket (P/O PL 80.10 Item 1)
19	-	Hinge pin (P/O PL 80.10 Item 1)
20	-	Front damper spring tensioner tool (P/O PL 31.14 Item 7) (See NOTE)

21	-	Rear damper spring tensioner tool (P/O PL 31.14 Item 7) (See NOTE)
22	-	Connector cover (P/O PL 80.10 Item 1)
23	803E36100	Duplex outer guide catch

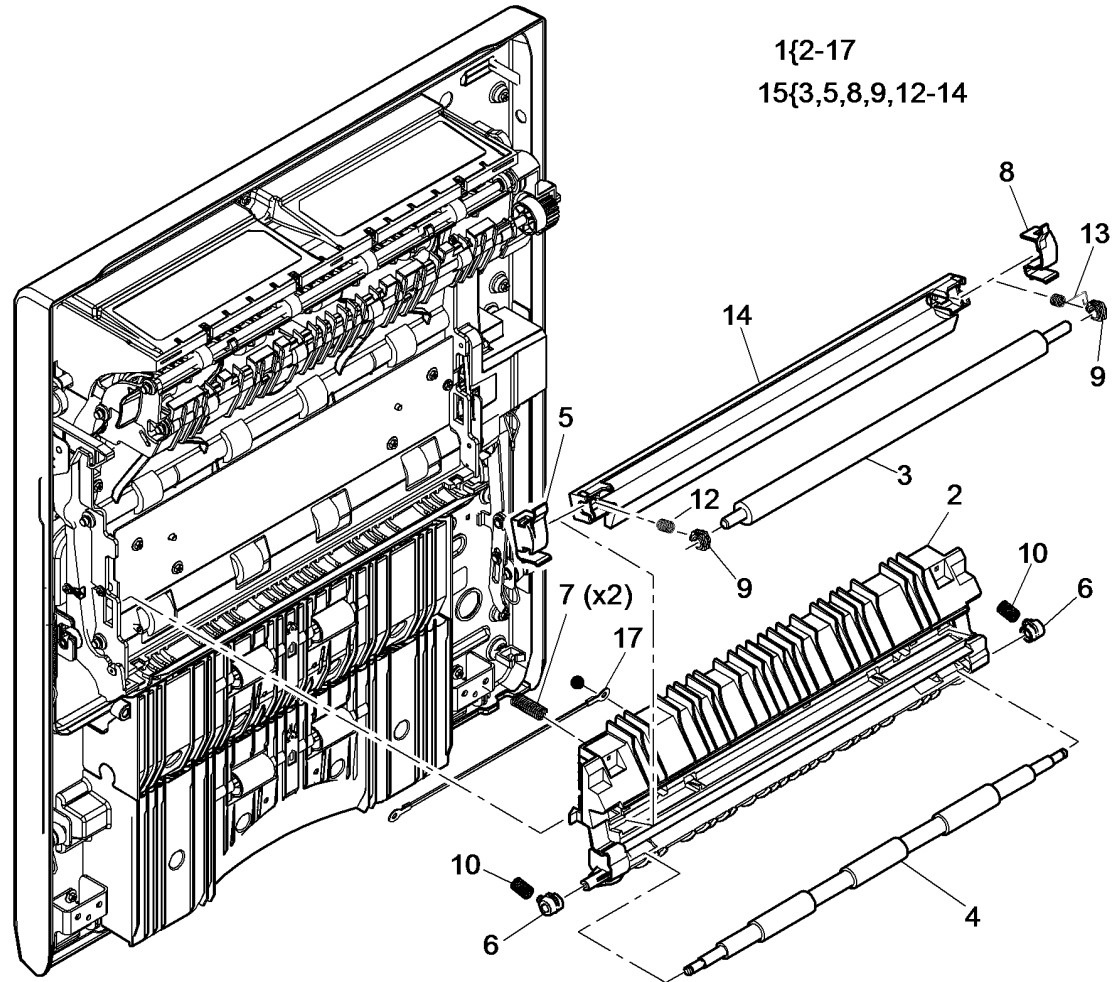
PL 80.15 Registration Transfer Assembly

Item	Part	Description
1	948K33130	Registration transfer assembly (REP 80.3)
2	-	Registration transfer housing (P/O PL 80.15 Item 1)
3	-	Bias transfer roll (P/O PL 80.15 Item 15)
4	-	Registration nip roll (P/O PL 80.15 Item 1) (REP 80.3)
5	-	Front retaining clip (P/O PL 80.15 Item 15)
6	-	Registration nip roll bearing (P/O PL 80.15 Item 1)
7	-	Spring (P/O PL 80.15 Item 1)
8	-	Rear retaining clamp (P/O PL 80.15 Item 15)
9	-	Bias transfer roll bearing (P/O PL 80.15 Item 15)
10	-	Support spring (P/O PL 80.15 Item 1)
11	-	Not used
12	-	Front housing spring (P/O PL 80.15 Item 15)
13	-	Rear housing spring (P/O PL 80.15 Item 15)
14	-	Bias transfer roll housing (P/O PL 80.15 Item 15)
15	008R13178	Bias transfer roll housing assembly
16	-	Not used
17	-	Ground strap (P/O PL 80.15 Item 1)

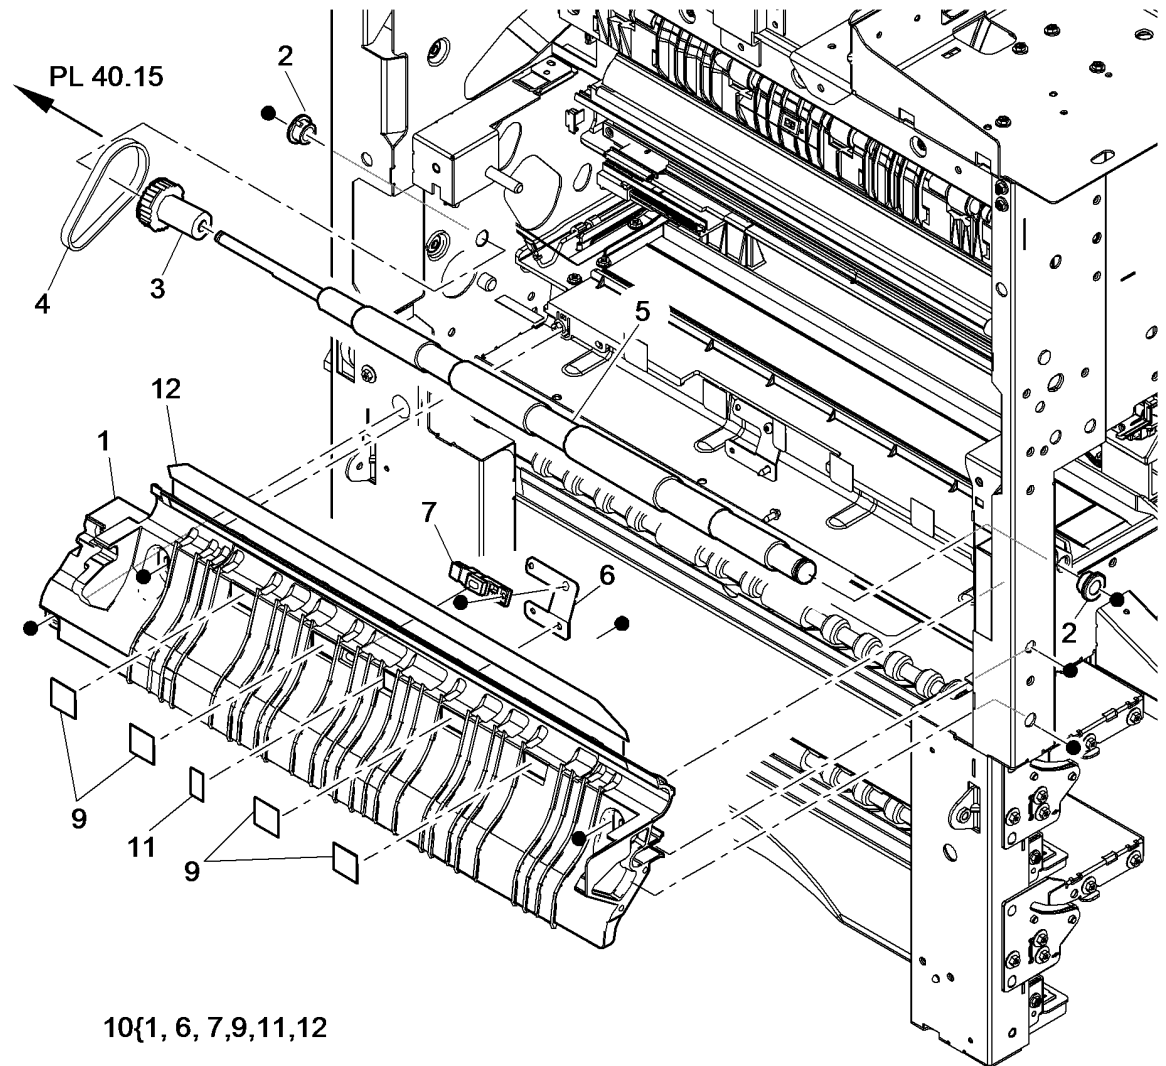
PL 80.17 Registration Transport

Item	Part	Description
1	-	Registration transport housing (P/O PL 80.17 Item 10) (REP 80.4)
2	-	Bearing (Not Spared)
3	-	Registration drive pulley (Not Spared) (ADJ 40.1)
4	-	Registration roll drive belt (Not Spared)
5	806E53400	Registration roll (REP 80.4)
6	-	Registration sensor bracket (P/O PL 80.17 Item 10)
7	-	Registration sensor (Q82-150) (P/O PL 80.17 Item 10) (REP 80.4)
8	-	Not used
9	-	Mylar (P/O PL 80.17 Item 10)
10	859K05394	Registration transport assembly (REP 80.4)
11	-	Mylar (P/O PL 80.17 Item 10)
12	038E52180	Pressure blade (See NOTE)

NOTE: Also supplied as part of PL 80.17 Item 10.

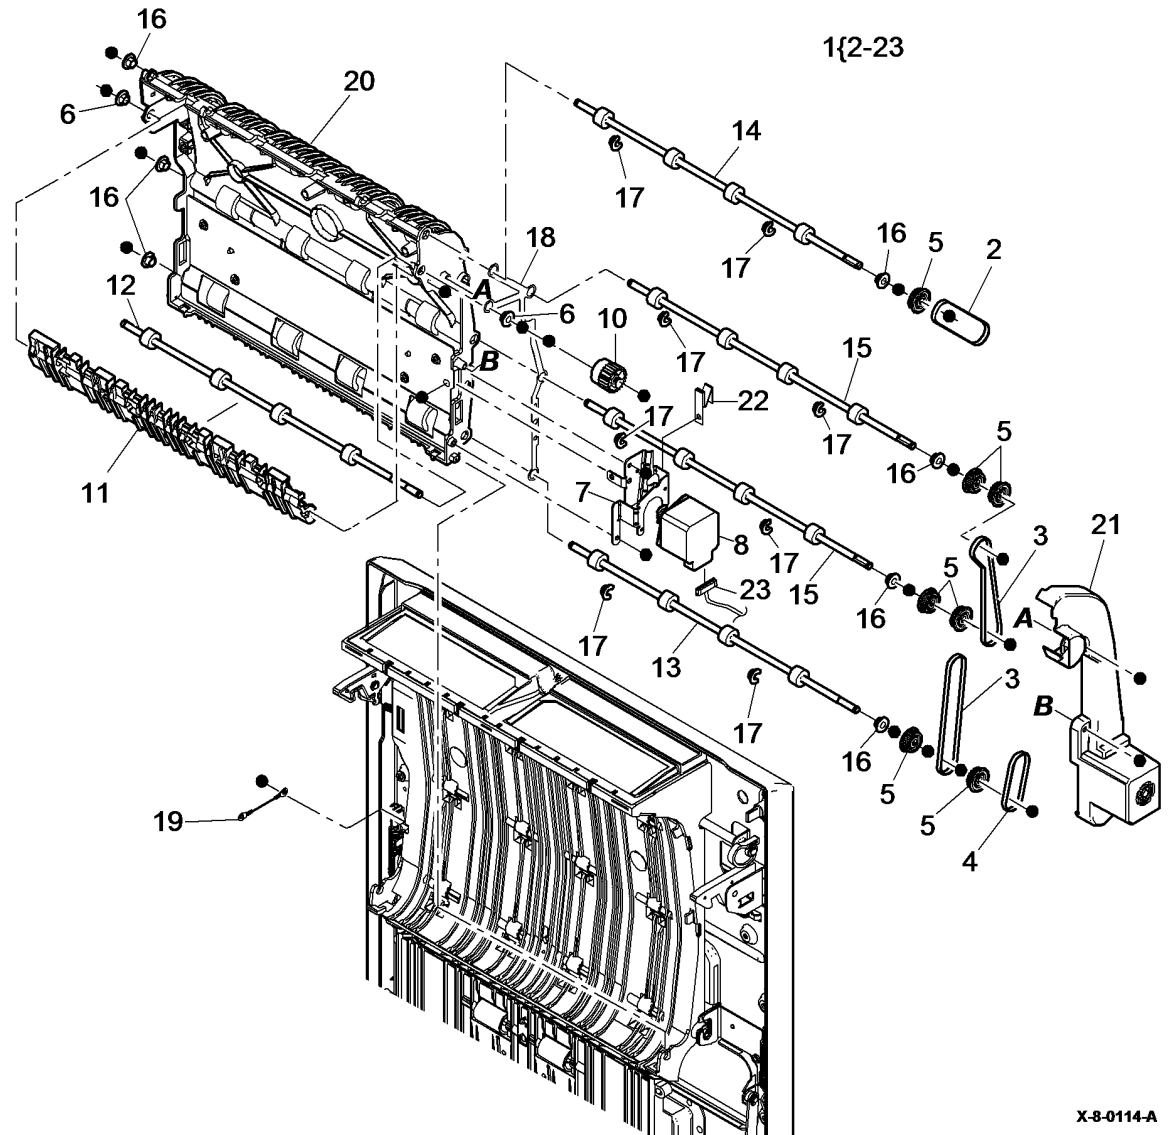
PL 80.22 Duplex Transport Assembly

Item	Part	Description
1	948K33121	Duplex transport assembly (45-55 ppm) (REP 80.5)
-	948K33151	Duplex transport assembly (65-90 ppm)
2	-	Drive belt (65T) (P/O PL 80.22 Item 1)
3	-	Drive belt (89T) (P/O PL 80.22 Item 1)
4	-	Drive belt (40T) (P/O PL 80.22 Item 1)
5	-	Pulley (21T) (P/O PL 80.22 Item 1)
6	-	Post fuser roll bearing (P/O PL 80.22 Item 1)
7	-	Mounting bracket (Not Spared) (REP 80.12)
8	-	Duplex motor assembly (P/O PL 80.22 Item 1) (45-55 ppm) (REP 80.12)

-	927K07900	Duplex motor assembly (65-90 ppm) (REP 80.12)
9	-	Not used
10	-	Gear (P/O PL 80.22 Item 1)
11	-	Post fuser guide (P/O PL 80.22 Item 1)
12	-	Post fuser roll (P/O PL 80.22 Item 1)
13	-	Lower duplex roll (P/O PL 80.22 Item 1)
14	-	Upper duplex roll (P/O PL 80.22 Item 1)
15	-	Mid duplex roll (P/O PL 80.22 Item 1)
16	-	Bearing (P/O PL 80.22 Item 1)
17	-	Half bearing (P/O PL 80.22 Item 1)
18	-	Ground strip (P/O PL 80.22 Item 1)
19	-	Limiter (P/O PL 80.22 Item 1)
20	-	Inner duplex door (P/O PL 80.22 Item 1)
21	-	Duplex drives cover (P/O PL 80.10 Item 1)
22	-	Ground contact strip (P/O PL 80.22 Item 1)
23	-	Duplex motor harness (P/O PL 80.10 Item 14) (REP 80.33)

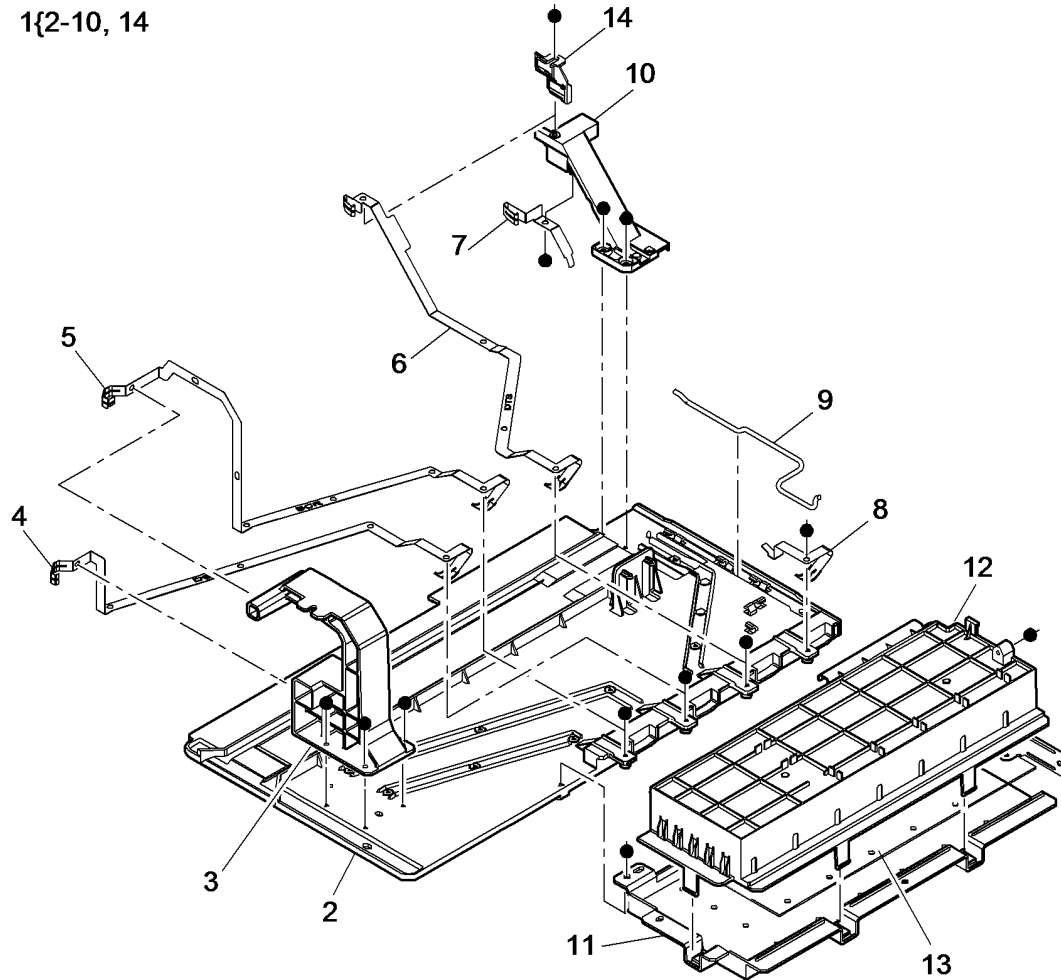
PL 90.15 Print Cartridge Cooling

Item	Part	Description
1	-	Print cartridge fan duct (Not Spared)
2	127E17991	Print cartridge fan
3	-	Inner cooling duct (Not Spared) (65-90ppm)
4	-	Environmental sensors PWB (Not Spared) (REP 90.4)
5	-	Outer cooling duct (Not Spared)

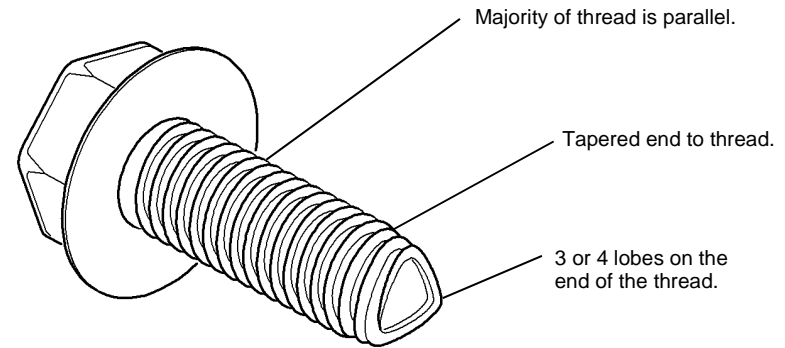
Figure 1 Thread forming screw

1. Ensure that the screw is a thread forming screw, refer to [Figure 1](#).

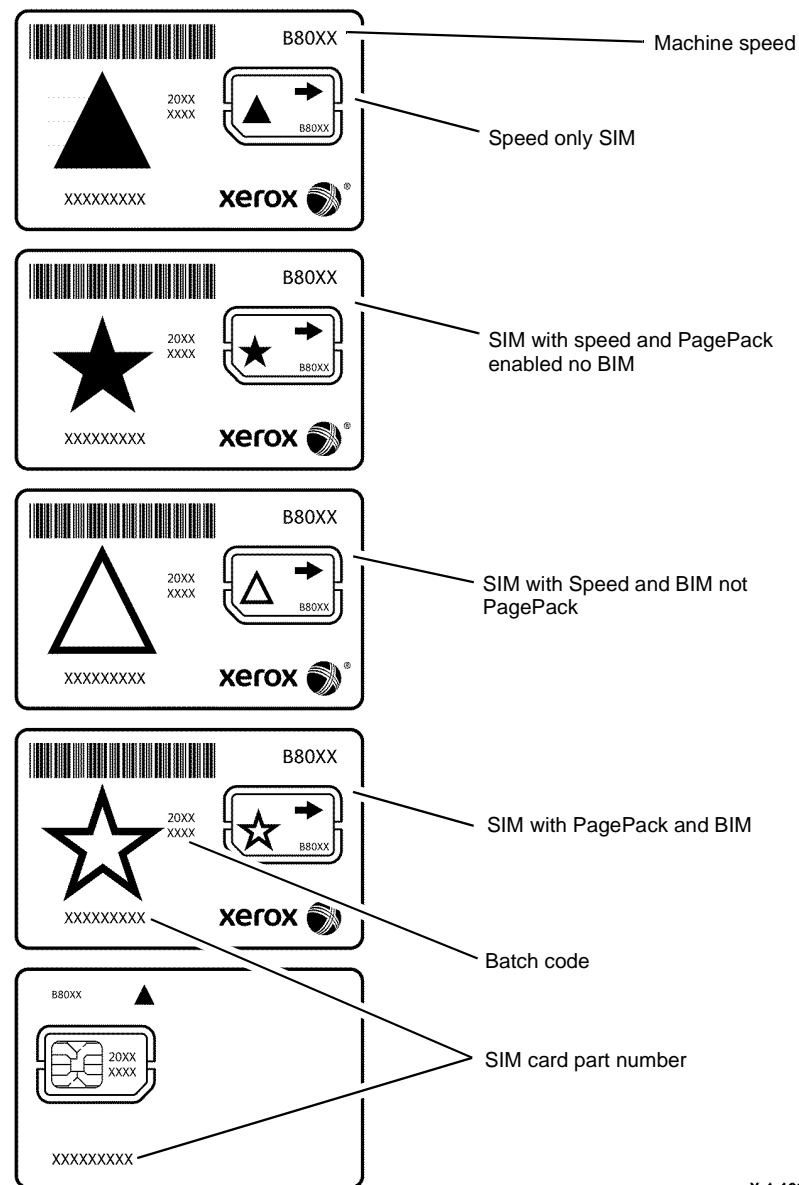
Figure 1 SIM cards

- The PagePack function is enabled in all XE installations. Depending on the customer's full service maintenance agreement, the PagePack function may need to be enabled when a USSG/XCL machine is installed in an XE region.
- A new SIM is pre-programmed with the machine speed and either PagePack and/or BIM enabled or not enabled. When the SIM is installed, the machine serial number is permanently written to the SIM. The SIM can not be reused in another machine.
- Each SIM card carries a batch code in date format.
- Each SIM card carries a part number that combines the designated machine speed and billing mode.

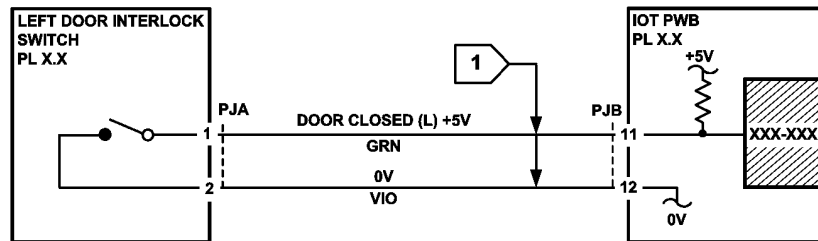
Figure 1 Circuit diagram

- [301B](#) 0V Distribution RAP.
- [301E](#) +5V Distribution RAP.
- [REP 1.2](#) Wiring Harness Repairs.

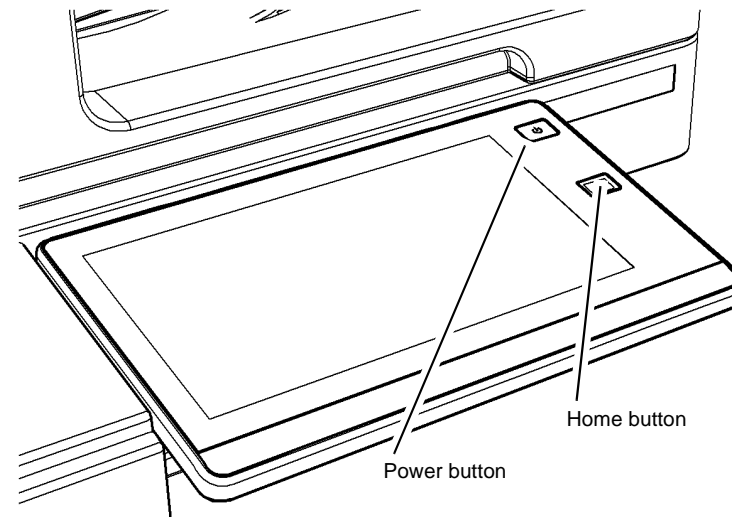
Figure 1 Power button

1. Press the Power button on the UI, [Figure 1](#). The Power Down Options window will display.

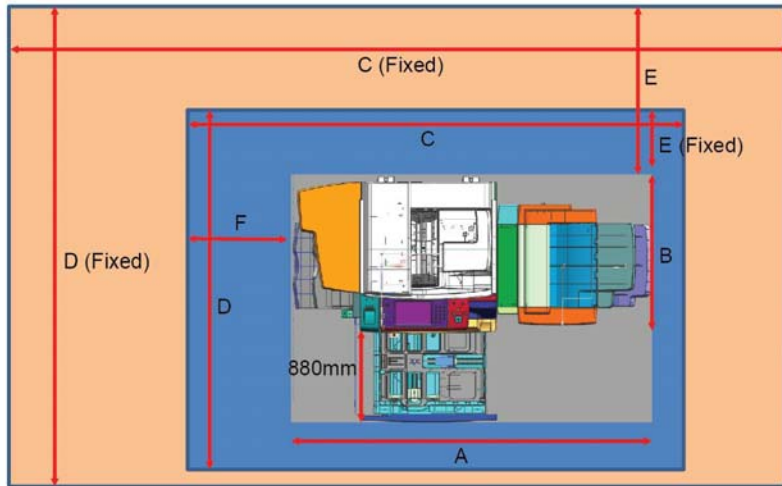
Figure 1 Installation plan

Configuration	Machine Width (A) mm/inches	Machine Depth (B) mm/inches	Install Width Required (C) mm/inches		Install Depth Required (D) mm/inches		Install Airflow/Service Work Space (E) mm/inches		Left Door Access Space (F) mm/inches
			Moveable	Fixed	Moveable	Fixed	Moveable	Fixed

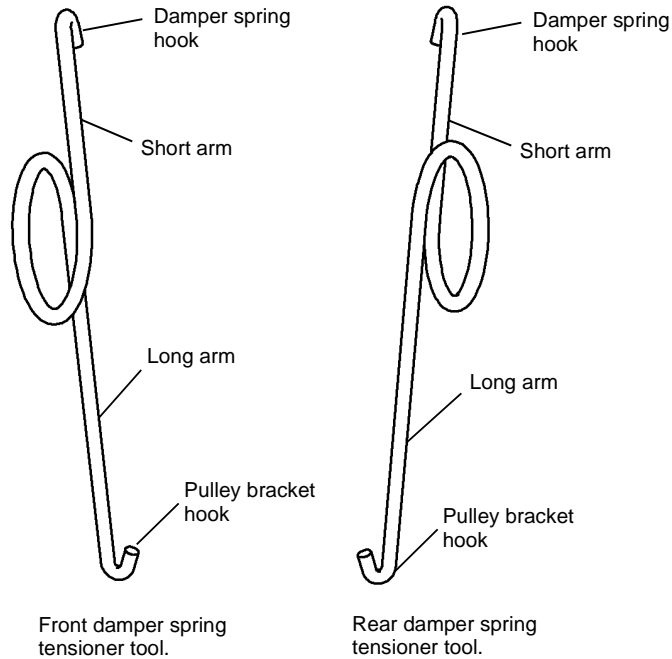
Figure 1 Tool identification

1. Ensure you have a damper spring tensioner tool kit before commencing this general procedure, PL 31.14 Item 7.
2. Ensure the machine is positioned in accordance with the minimum safe working space requirement, GP 21.
3. Ensure both the front castors are locked, PL 70.26 Item 3.
4. Remove the lower rear cover, PL 70.26 Item 1. This cover is utilized to support the left door assembly in the service position.
5. Remove the print cartridge, PL 90.17 Item 9, then place in a lightproof bag.
6. Identify the front and rear spring tensioner tools, Figure 1.

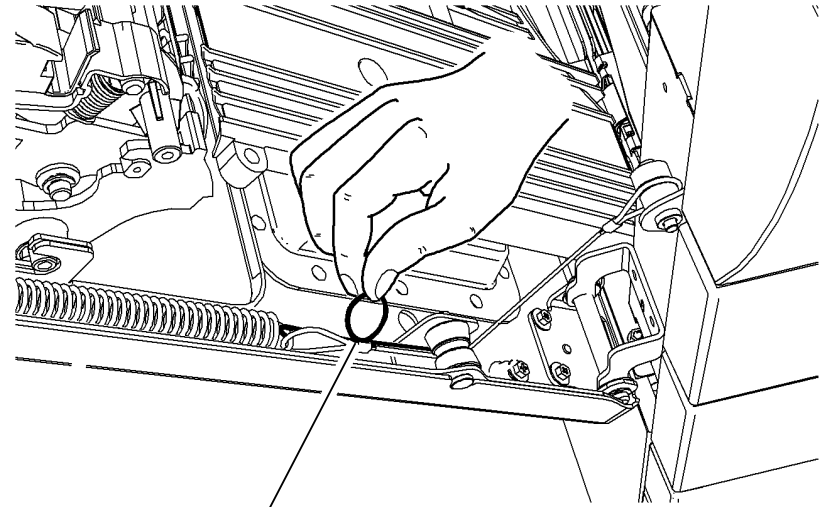
X-1-1335-A

- 1 With the left door fully open install the front damper spring tensioner tool.

Figure 2 Front damper spring tensioner tool

7. Install the front and rear damper spring tensioner tools. Hook the short arm of each tool to the bottom loop of the respective damper spring, then hook the long arm to the inner side of the pulley bracket, Figure 2 and Figure 3.

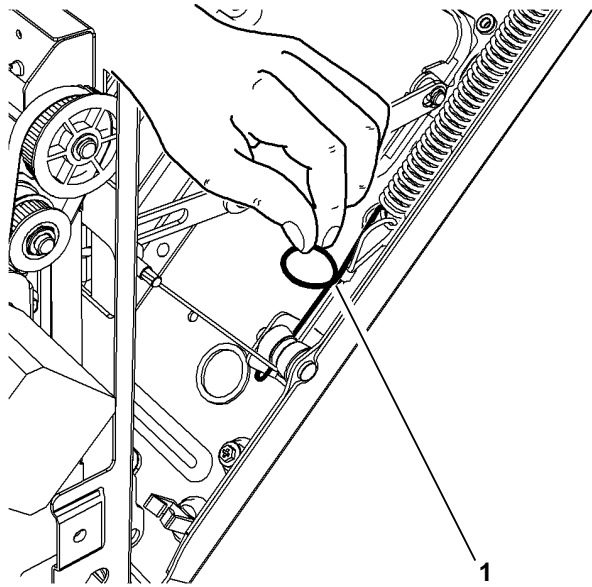
X-1-1336-A

1
With the left door fully open install the rear damper spring tensioner tool.

Figure 3 Rear damper spring tensioner tool

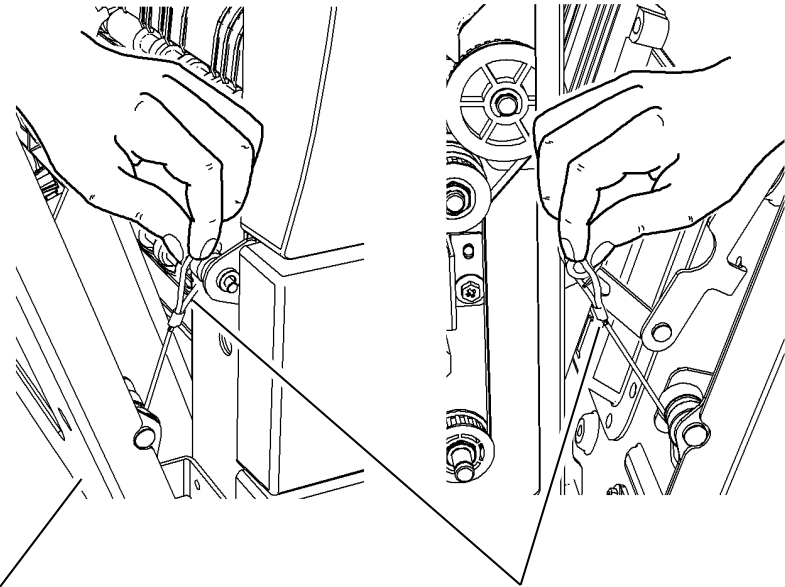
1
Partially close the left door, leaving just sufficient access to the looped ends of the front and rear damper cables.

2
Pull the damper cables off the front and rear anchor pulleys.

8. Release the front and rear damper cables, [Figure 4](#).

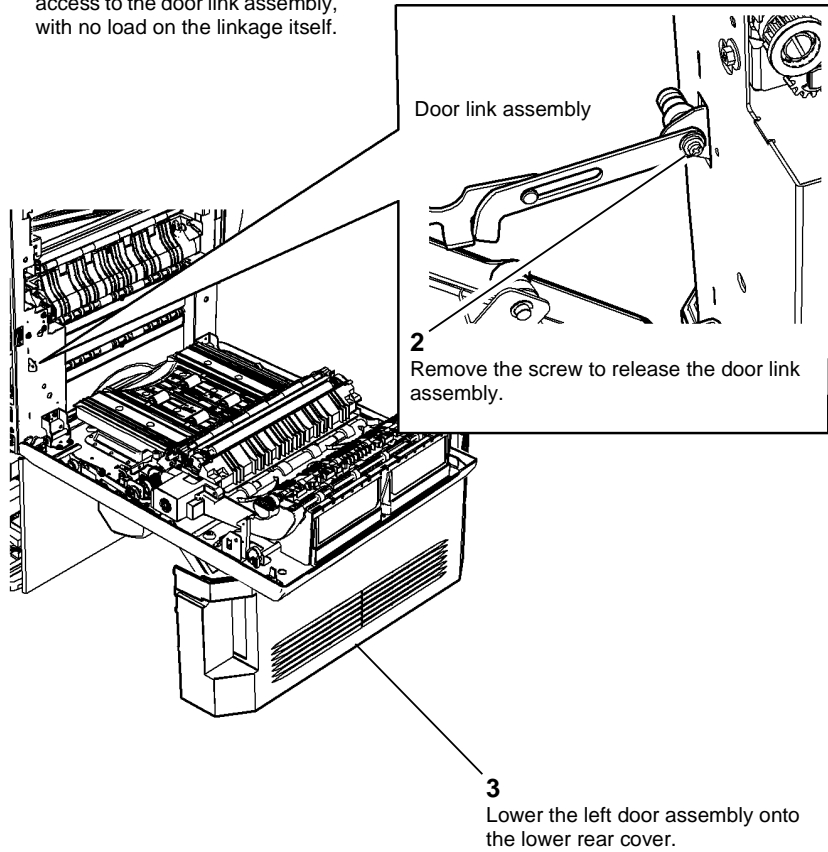
X-1-1343-A

Lower, then hold the left door assembly in a position to allow access to the door link assembly, with no load on the linkage itself.

Figure 5 Left door service position

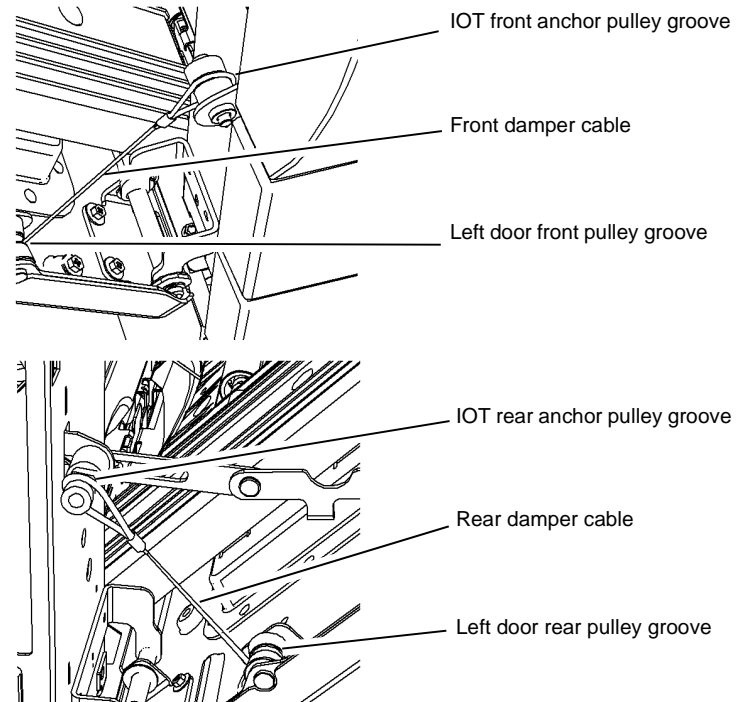
X-1-1344-A

Figure 6 Pulley grooves

- The replacement is the reverse of the removal procedure.
- Ensure the front and rear damper cables are located in the grooves of their pulleys, [Figure 6](#).

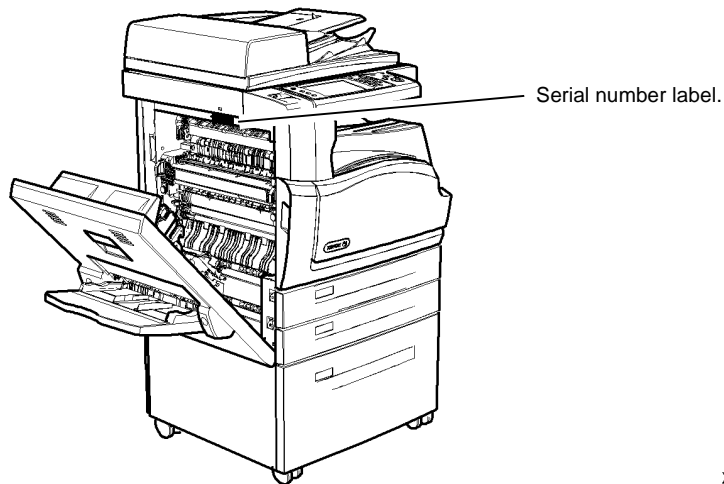
X-1-1353-A

Figure 1 Label location

1. Enter service mode, [GP 1](#).
2. Select the Maintenance tab.
3. Select dC132 Machine Serial Number.
4. The machine identifier code (serial number) or '#####' is displayed.
5. If the displayed serial number does not match the number on the serial number label ([Figure 1](#)) or '#####' is displayed, the serial number is corrupt. Perform [Serial Number Restore](#).

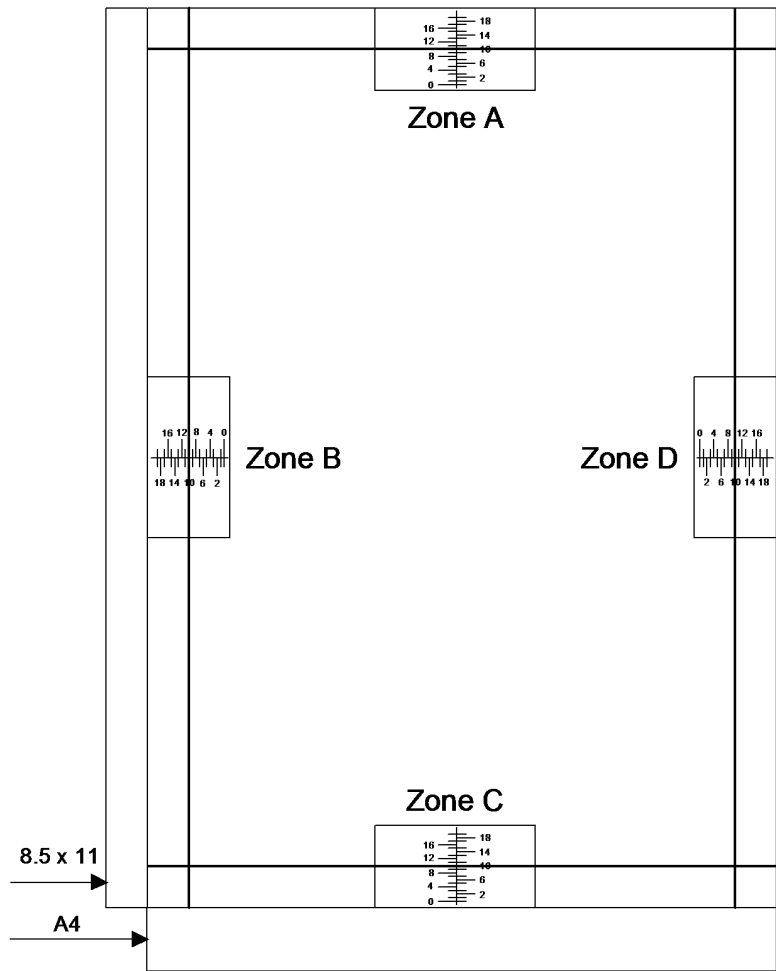
X-1-1308-A

Figure 1 Registration test pattern

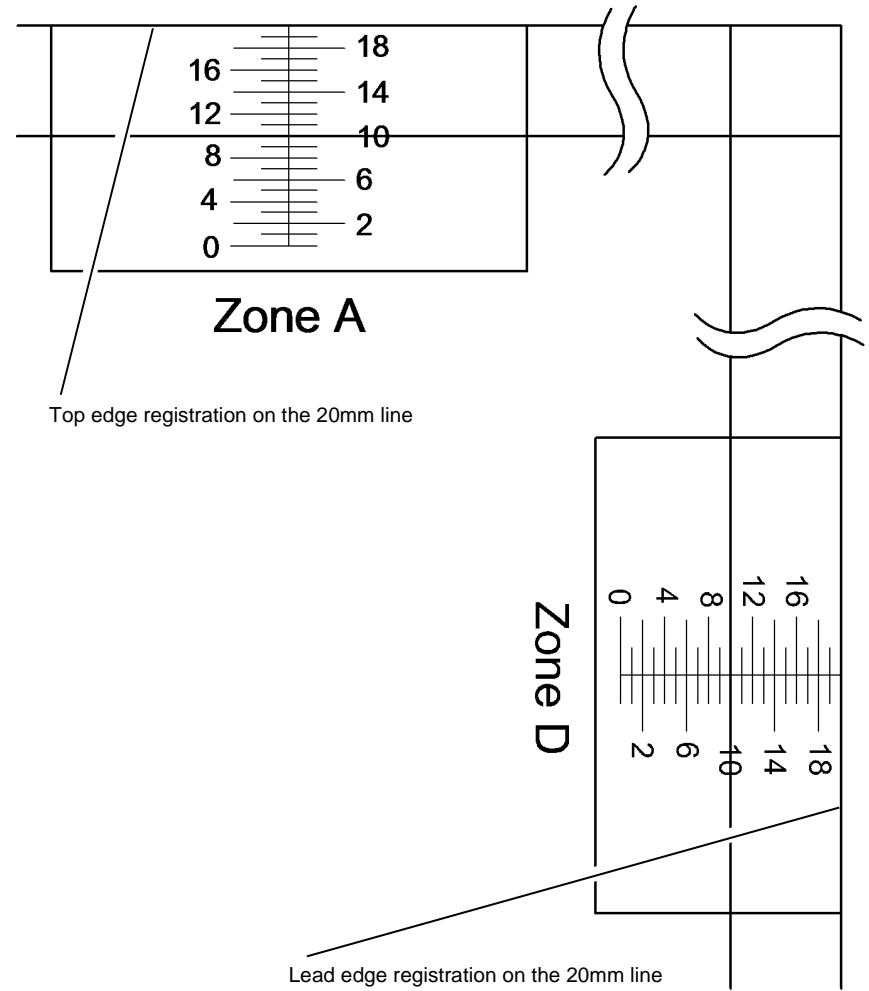
X-1-1309-A

Figure 2 IOT registration

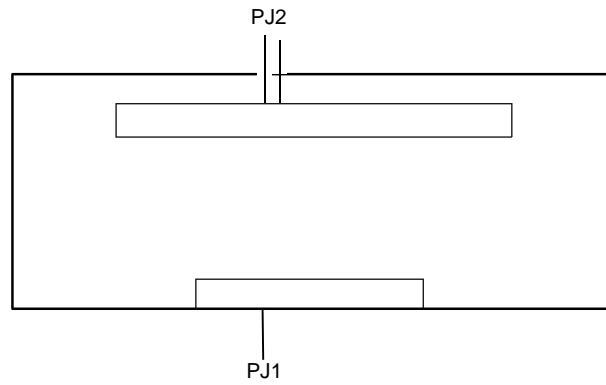
X-10898-A

Location: [PL 20.05 Item 4.](#)

Figure 4 Fax connector PWB

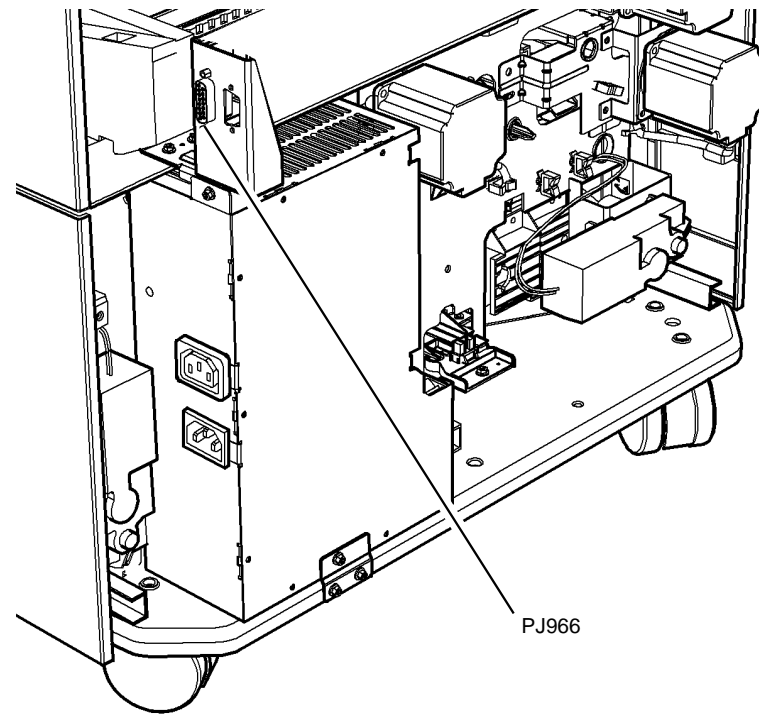
X-1-1306-A

Location: [PL 1.10.](#)

Figure 5 Finisher communications connector

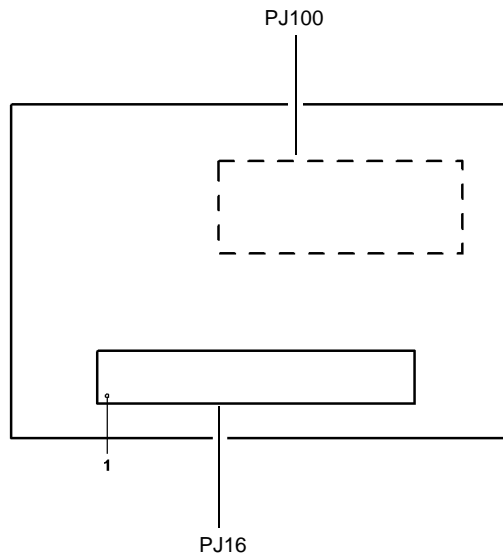
X-1-0897-A

Location: PL 3.22 Item 18.

Figure 6 Foreign device interface PWB

PJ Number	Figure No.	PJ location	Wiring Diagram
2 (HVF)	Figure 10	Insertter PWB	WD 45
3 (HVF)	Figure 10	Insertter PWB	WD 45
4 (HVF)	Figure 10	Insertter PWB	WD 45
4 (HVF)	Figure 10	Insertter PWB	WD 46
5 (HVF)	Figure 10	Insertter PWB	WD 45
6 (HVF)	Figure 10	Insertter PWB	WD 45
7 (HVF)	Figure 10	Insertter PWB	WD 45
8 (HVF)	Figure 10	Insertter PWB	WD 45
8 (HVF)	Figure 10	Insertter PWB	WD 46
9 (HVF)	Figure 10	Insertter PWB	WD 46
10 (HVF)	Figure 10	Insertter PWB	WD 46
11 (HVF)	Figure 10	Insertter PWB	WD 46
12 (HVF)	Figure 10	Insertter PWB	WD 46
16	Figure 6	Foreign device interface PWB	WD 4
25	Figure 24	SBC PWB	WD 3

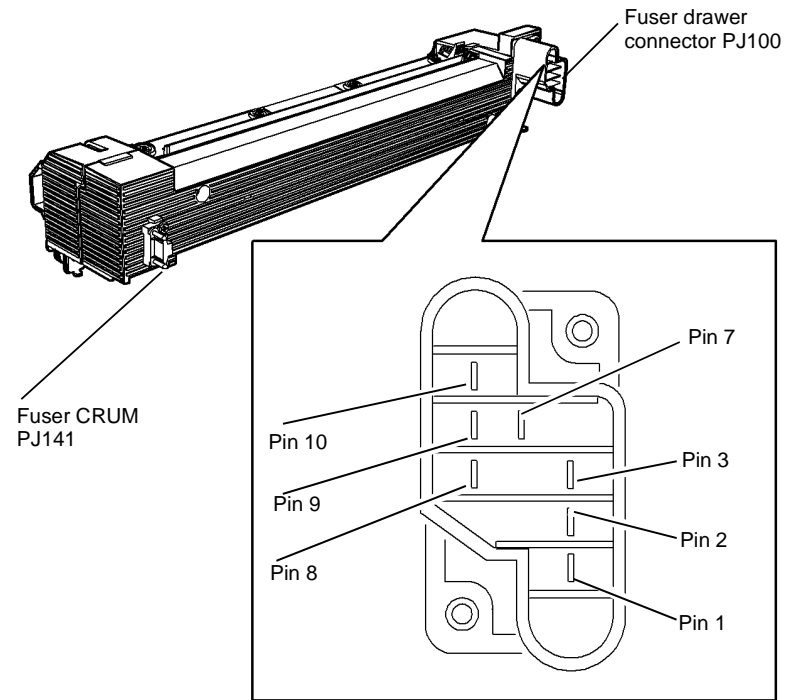
X-1-1304-A

Location: PL 10.10 Item 1.

Figure 7 Fuser module

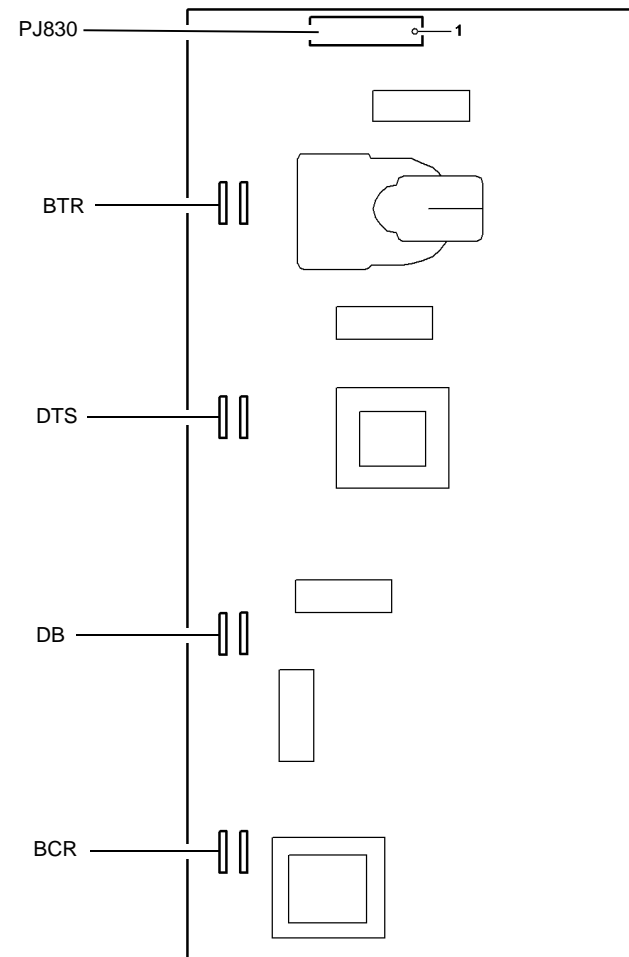
Location: PL 1.10 Item 4.

Figure 9 HVPS

PJ Number	Figure No.	PJ Location	Wiring Diagram
802 (HVF)	Figure 8	HVF PWB	WD 39
830	Figure 9	HVPS	WD 10
850	Figure 24	SBC PWB	WD 2
851	Figure 24	SBC PWB	WD 2
852	Figure 24	SBC PWB	WD 2
853	Figure 24	SBC PWB	WD 2
861	Figure 24	SBC PWB	WD 3
864	Figure 24	SBC PWB	WD 4
865	Figure 24	SBC PWB	WD 4
866	Figure 24	SBC PWB	WD 10, WD 4
867	Figure 24	SBC PWB	WD 4
880	Figure 24	SBC PWB	WD 4
881	Figure 24	SBC PWB	WD 4
882	Figure 24	SBC PWB	WD 4
889	Figure 24	SBC PWB	WD 4

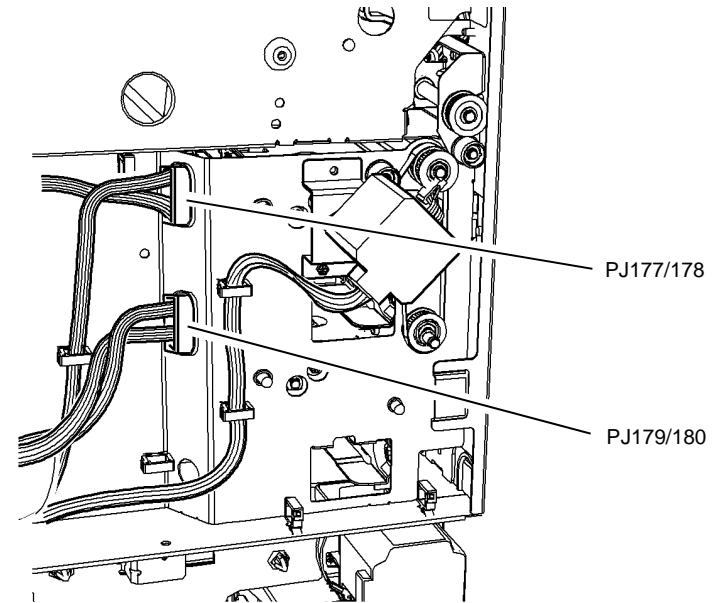
X-1-1166-A

In-line Connectors PJ177/178 and PJ179/180

Location: [PL 80.26](#).

Figure 11 In-line connectors

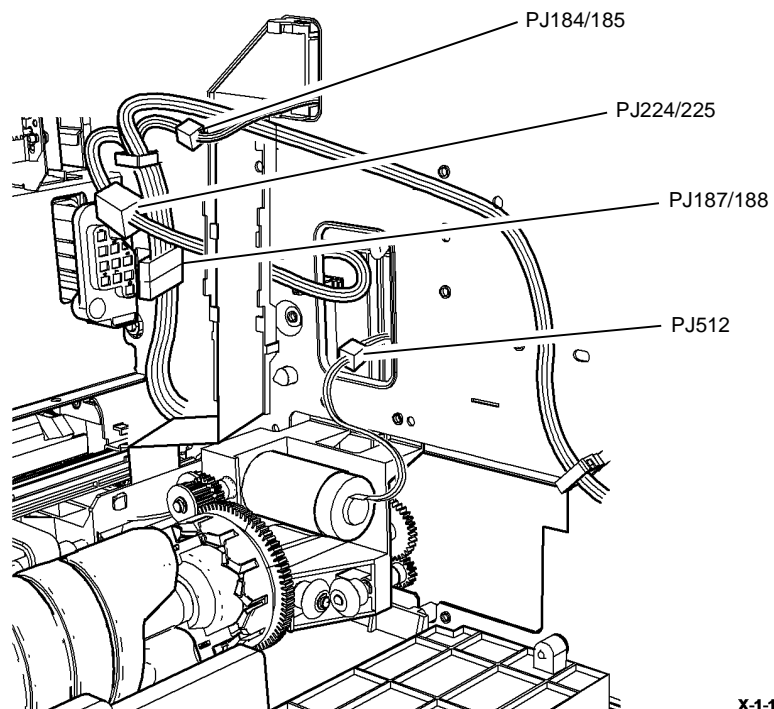
X-1-1170-A

In-line Connectors PJ184/185, 187/188, PJ224/225 and PJ512

Location: [PL 10.11](#), [PL 10.13](#) and [PL 90.17](#).

Figure 12 In-line connectors

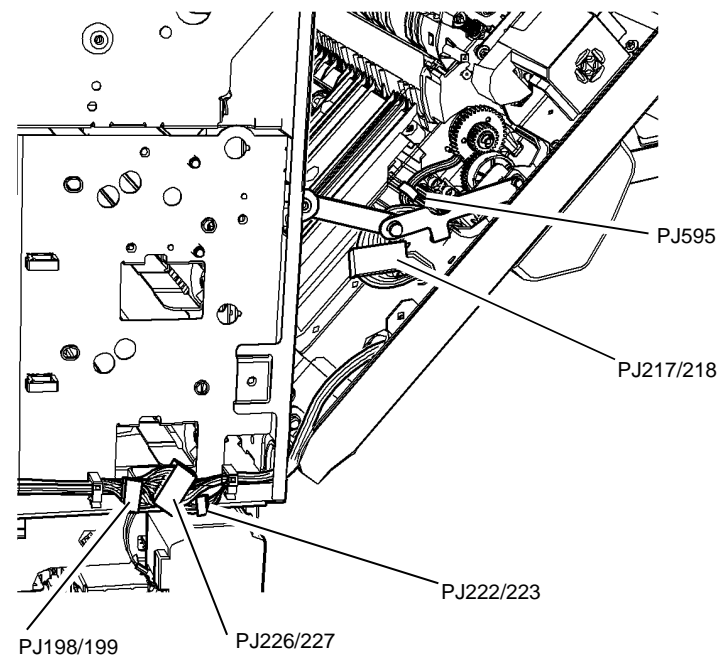
X-1-1165-A

Location: [PL 70.21](#).

NOTE: For clarity, the connector cover, [PL 80.11 Item 22](#) is not shown in [Figure 13](#).

Figure 13 In-line connectors
