708P91368
September 2017

Xerox® AltaLink® B8090 Family Multifunction Printer Service Manual

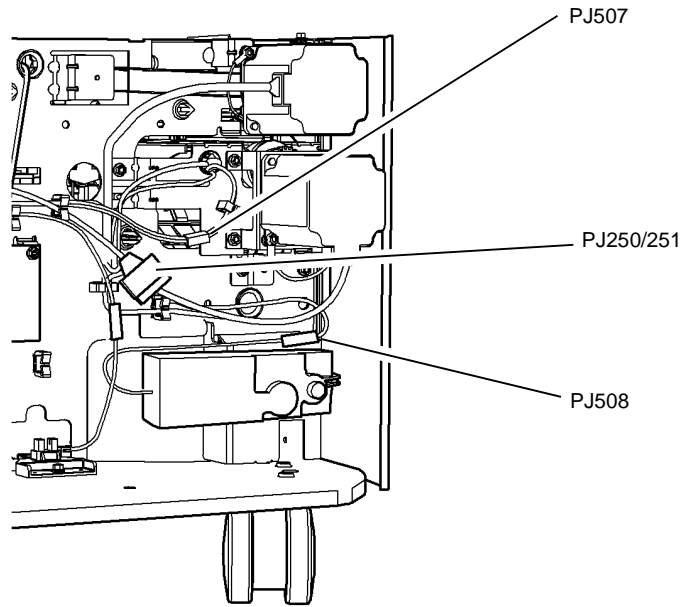
X-1-1302-A

In-line Connectors PJ250/251, PJ507, PJ508 and PJ514

Location: [PL 70.21](#).

Figure 14 In-line connectors

PJ Number	Figure No.	PJ Location	Wiring Diagram
501 (HVF)	Figure 8	HVF PWB	WD 36
502 (HVF)	Figure 8	HVF PWB	WD 37
503 (HVF)	Figure 8	HVF PWB	WD 48
507	Figure 14	In-line connector tray 3 feed clutch	WD 7
508	Figure 14	In-line connector tray 3 elevator motor	WD 7
510	Figure 23	Print cartridge	WD 9
511	Figure 18	LED print head module	WD 2
512	Figure 12	In-line connector	WD 9
513	Figure 23	Print cartridge	WD 9
537	Figure 28	Tray 1 paper size sensing PWB	WD 5
544	Figure 29	Tray 2 paper size sensing PWB	WD 5
551 (HVF)	Figure 2	BM PWB	WD 40
551 (HVF)	Figure 2	BM PWB	WD 40
552 (HVF)	Figure 2	BM PWB	WD 40
552 (HVF)	Figure 2	BM PWB	WD 41
553 (HVF)	Figure 2	BM PWB	WD 30
553 (HVF)	Figure 2	BM PWB	WD 41
554 (HVF)	Figure 2	BM PWB	WD 41
554 (HVF)	Figure 2	BM PWB	WD 41
555 (HVF)	Figure 2	BM PWB	WD 41
555 (HVF)	Figure 2	BM PWB	WD 42
556 (HVF)	Figure 2	BM PWB	WD 42
556 (HVF)	Figure 2	BM PWB	WD 42
557 (HVF)	Figure 2	BM PWB	WD 42
559 (HVF)	Figure 2	BM PWB	WD 30

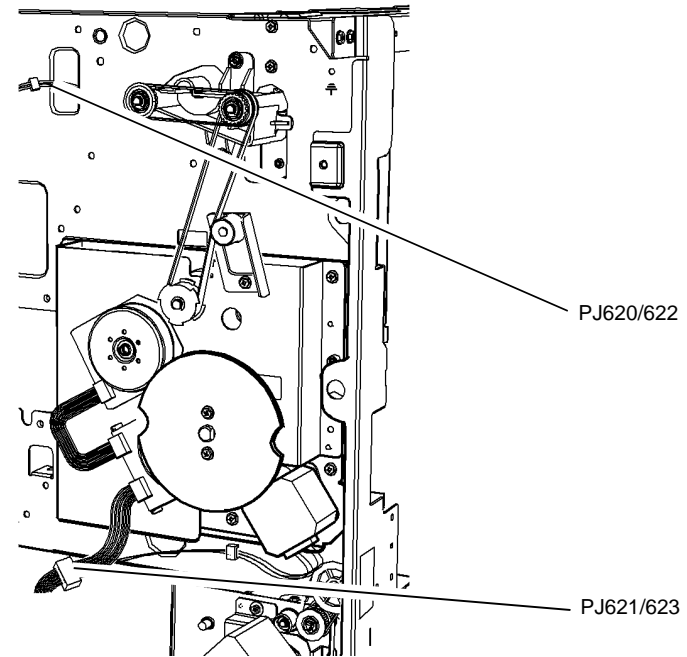
X-1-1380-A

In-line Connectors PJ620/622 and PJ621/623

Location: [PL 40.15](#).

Figure 15 In-line connector

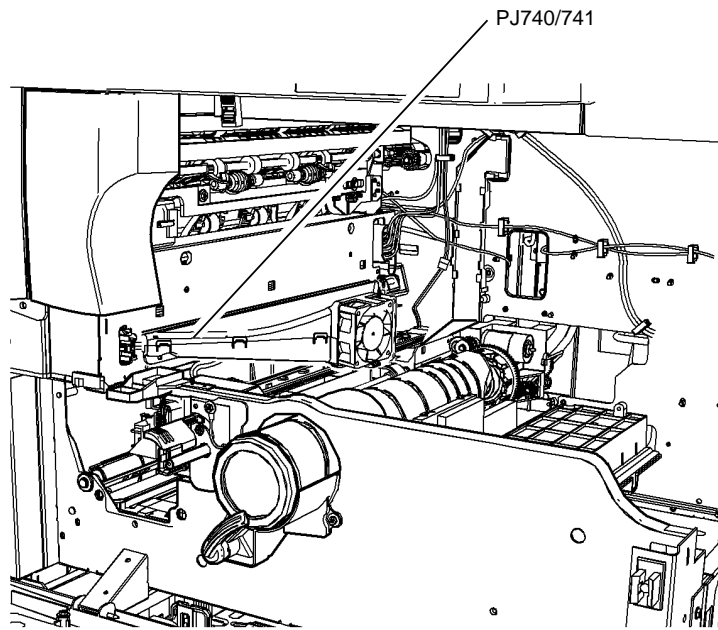
X-1-1312-A

In-line Connector PJ740/741

Location: [PL 60.35](#).

Figure 16 In-line connector

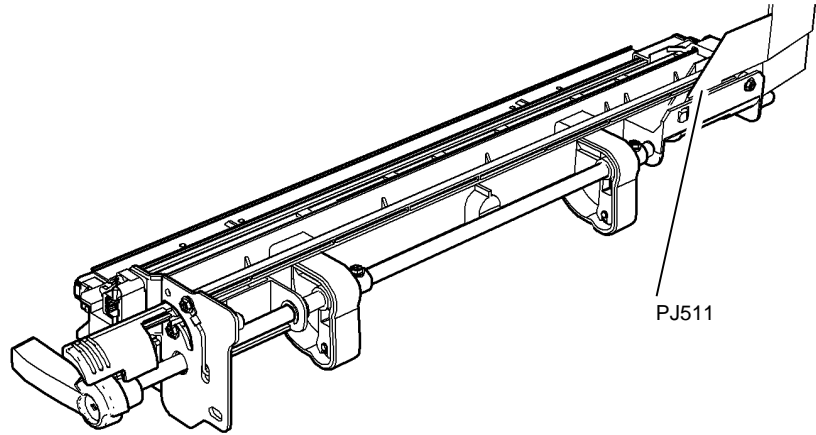
X-1-0953-A

Location: [PL 60.35 Item 1.](#)

Figure 18 LED print head module

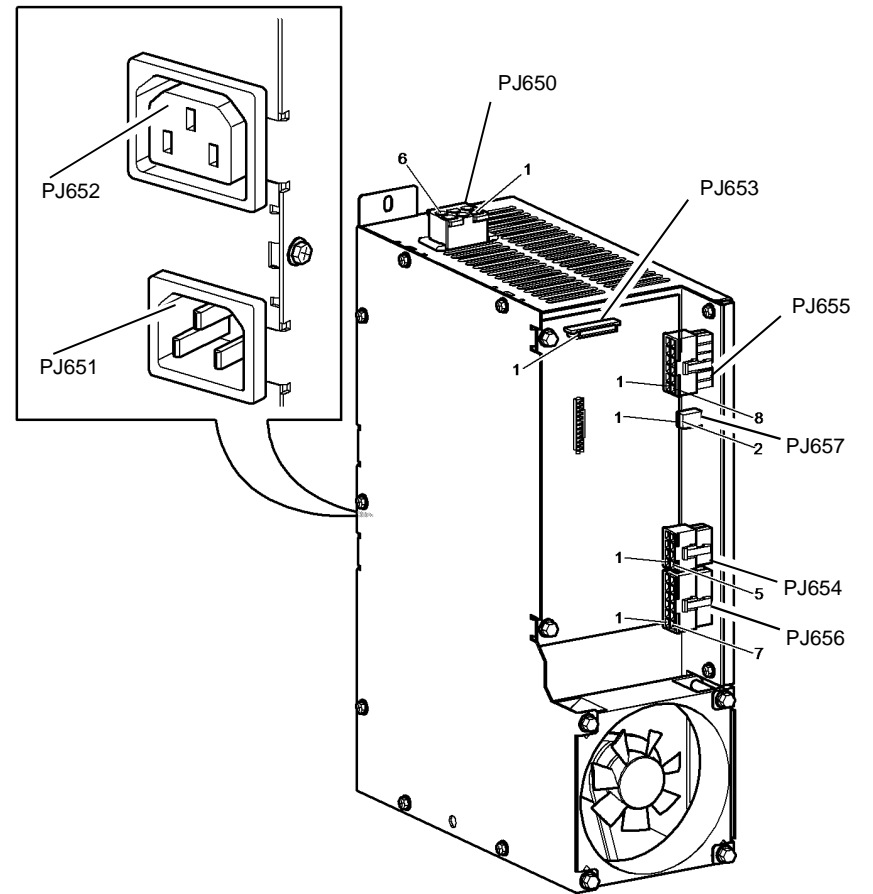
Location: PL 1.10 Item 1.

Figure 21 LVPS

PJ Number	Figure No.	PJ Location	Wiring Diagram
601 (HVF)	Figure 31	Tri-folder PWB	WD 30
601 (HVF)	Figure 8	HVF PWB	WD 37
601 (HVF)	Figure 8	HVF PWB	WD 37
601 (HVF)	Figure 31	Tri folder PWB	WD 44
602 (HVF)	Figure 8	HVF PWB	WD 37
602 (HVF)	Figure 31	Tri folder PWB	WD 44
603 (HVF)	Figure 31	Tri folder PWB	WD 44
604 (HVF)	Figure 31	Tri folder PWB	WD 44
605 (HVF)	Figure 31	Tri folder PWB	WD 44
606 (HVF)		In-line connector	WD 44
620	Figure 15	In-line connector IOT PWB side	WD 9
621	Figure 15	In-line connector LVPS side	WD 1
622	Figure 15	In-line connector fuser side	WD 9
623	Figure 15	In-line connector main drive module side	WD 1
650	Figure 21	LVPS	WD 1, WD 9
651	Figure 21	LVPS	WD 1
652	Figure 21	LVPS	WD 1
653	Figure 21	LVPS	WD 1, WD 9
654	Figure 21	LVPS	WD 1, WD 12
655	Figure 21	LVPS	WD 1, WD 2
656	Figure 21	LVPS	WD 30, WD 1,
660 (HVF)		In-line connector HVFBM bin 2 assembly	WD 42

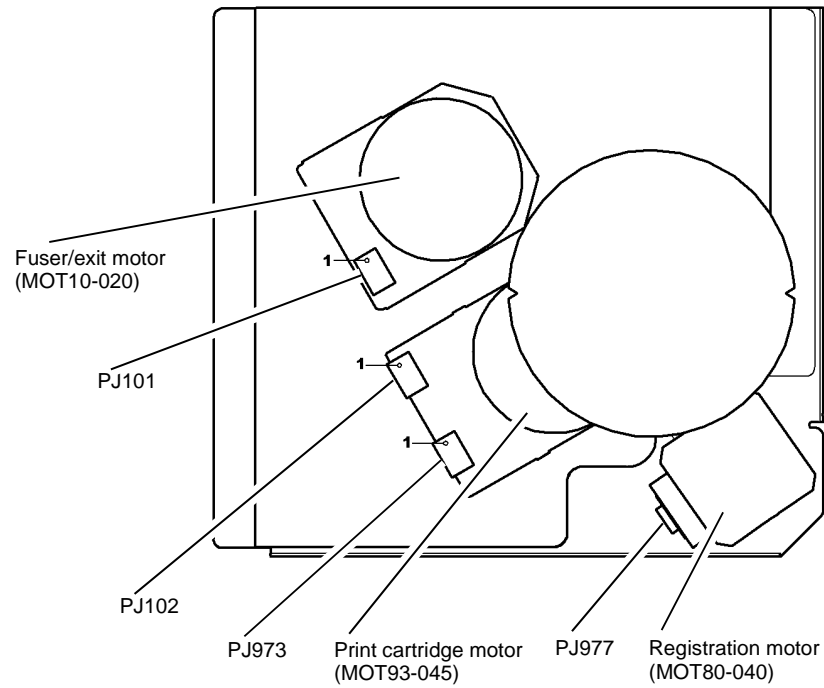
X-1-0958-A

Location: PL 40.15 Item 1.

Figure 22 Main drive module

22. Main drive module, [Figure 22](#).
23. Print cartridge, [Figure 23](#).
24. SBC PWB, [Figure 24](#).
25. Scanner PWB, [Figure 25](#).
26. SPDH PWB, [Figure 26](#).

PJ Number	Figure No.	PJ Location	Wiring Diagram
901 (HVF)	Figure 8	HVF PWB	WD 39
902	Figure 32	UI control PWB	WD 4
911		In-line connector	WD 4
920	Figure 34	UI interface PWB	WD 4
921	Figure 34	UI interface PWB	WD 4
922	Figure 34	UI interface PWB	WD 4
973	Figure 22	Main drive module	WD 1
977	Figure 22	Main drive module	WD 8
982		Environmental sensors PWB	WD 8

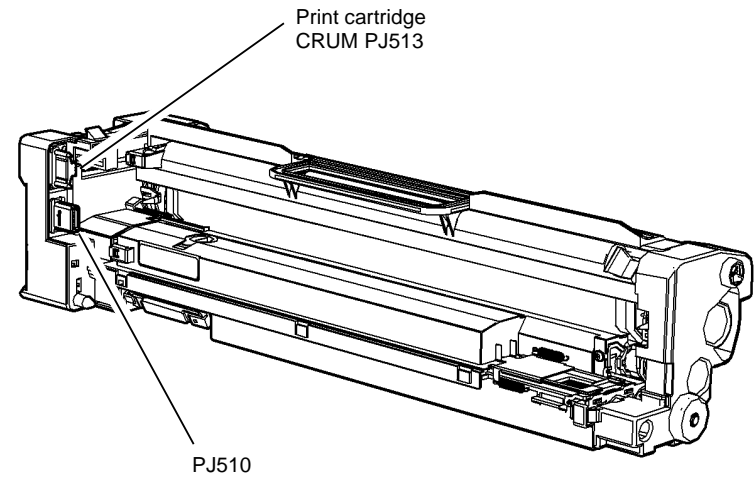
X-1-1305-A

Location: PL 90.17 Item 9.

Figure 23 Print cartridge

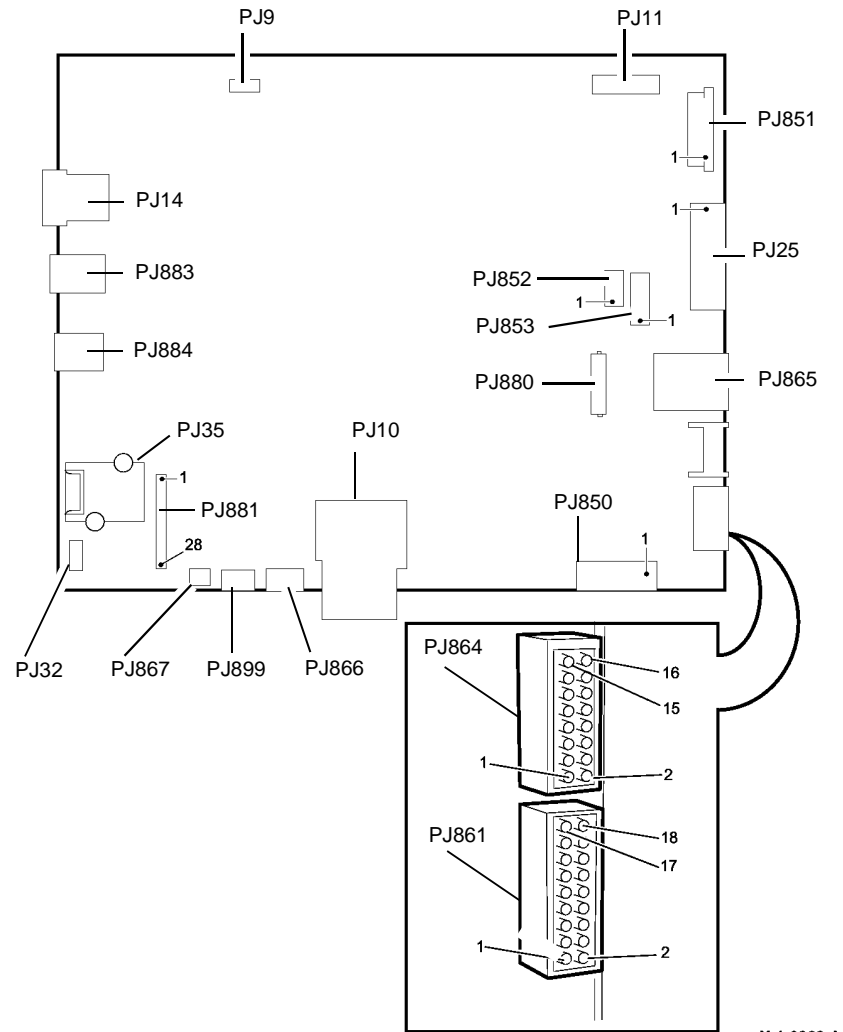
X-1-0868-A

Location: PL 3.22 Item 3.

Figure 24 SBC PWB

PJ Number	Figure No.	PJ Location	Wiring Diagram
802 (HVF)	Figure 8	HVF PWB	WD 39
830	Figure 9	HVPS	WD 10
850	Figure 24	SBC PWB	WD 2
851	Figure 24	SBC PWB	WD 2
852	Figure 24	SBC PWB	WD 2
853	Figure 24	SBC PWB	WD 2
861	Figure 24	SBC PWB	WD 3
864	Figure 24	SBC PWB	WD 4
865	Figure 24	SBC PWB	WD 4
866	Figure 24	SBC PWB	WD 10, WD 4
867	Figure 24	SBC PWB	WD 4
880	Figure 24	SBC PWB	WD 4
881	Figure 24	SBC PWB	WD 4
882	Figure 24	SBC PWB	WD 4
889	Figure 24	SBC PWB	WD 4

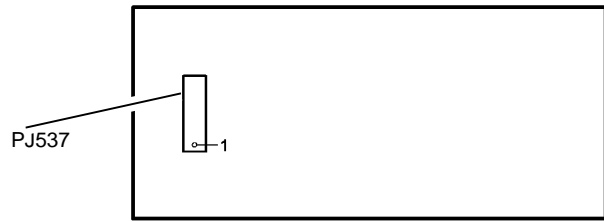
Location: PL 70.10 Item 18.

Figure 28 Tray 1 paper size sensing PWB

27. Toner cartridge PWB, [Figure 27](#).
28. Tray 1 paper size sensing PWB, [Figure 28](#).
29. Tray 2 paper size sensing PWB, [Figure 29](#).
30. Tray 6 control PWB, [Figure 30](#).

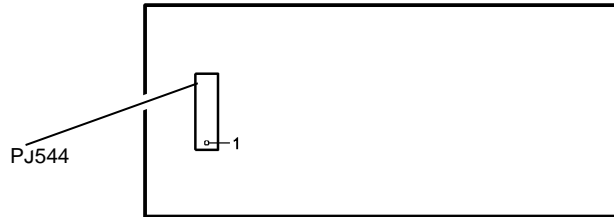
Location: PL 70.10 Item 18.

Figure 29 Tray 2 paper size sensing PWB

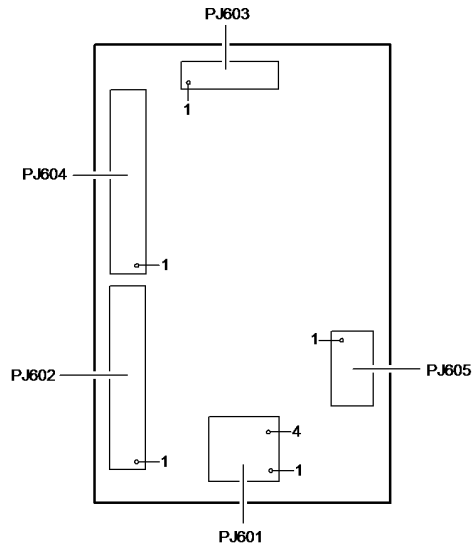
X-1-2004-A

Location: PL 2.10 Item 1

Figure 31 Tri-folder PWB

31. Tri folder PWB, [Figure 31](#).
32. UI control PWB, [Figure 32](#).
33. UI emotive PWB, [Figure 33](#).
34. UI interface PWB, [Figure 34](#).
35. UI Status PWB, [Figure 35](#).

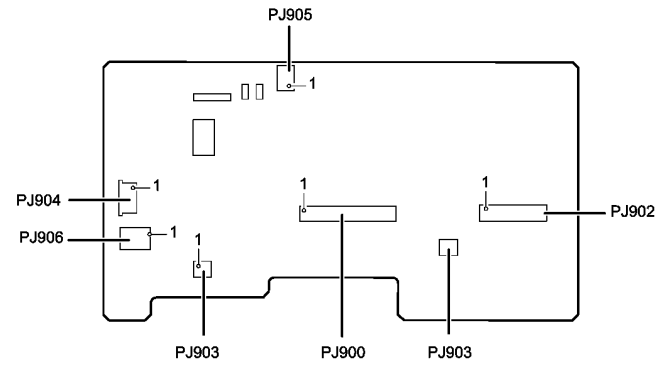
X-1-2005-A

Location: Part of PL 2.10 Item 1

Figure 32 UI control PWB

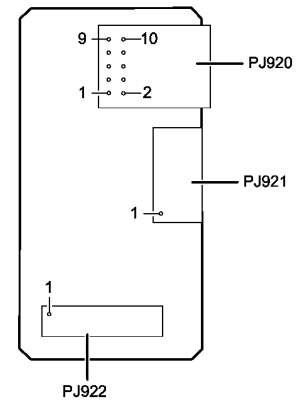
X-1-2007-A

Location: Part of PL 2.10 Item 15.

Figure 34 UI interface PWB

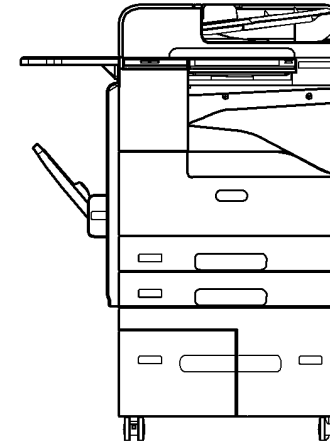
Figure 1 With centre output tray and workshelf

- [Figure 1](#) AltaLink® B8075 with centre output tray and workshelf.
- [Figure 2](#) AltaLink® B8055 with 2K LCSS.
- [Figure 3](#) AltaLink® B8065/B8075 with LVF BM.
- [Figure 4](#) AltaLink® B8090 with tray 6, HVF BM, inserter and tri folder.

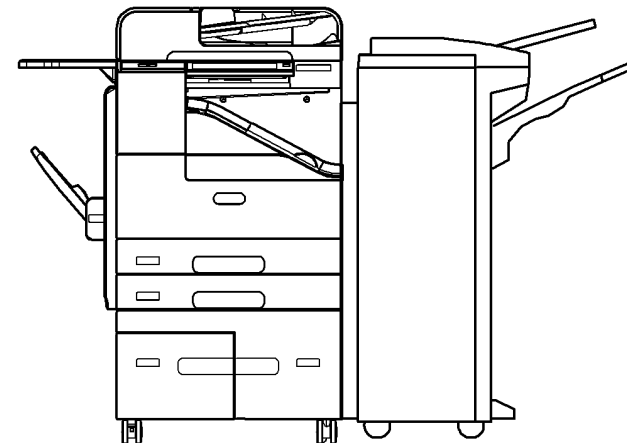
Figure 2 Machine with 2K LCSS

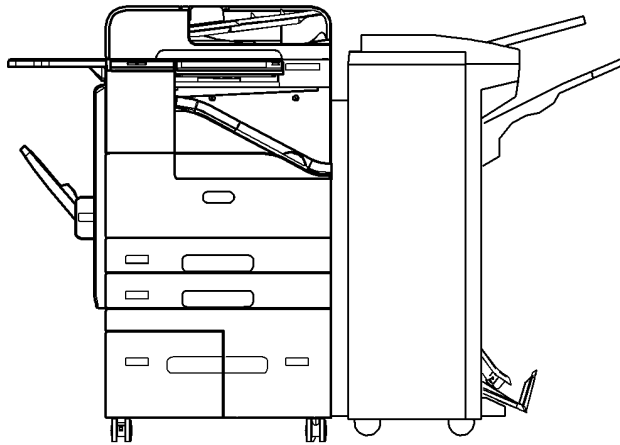
Figure 3 Machine with LVB BM

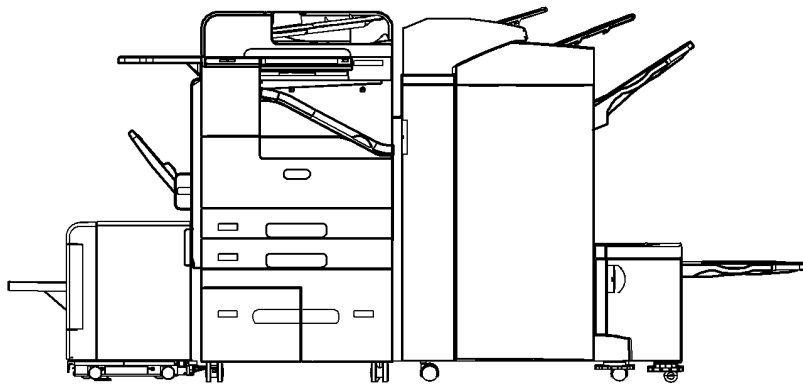
Figure 4 With tray 6, HVB BM, tray 7, tri-folder

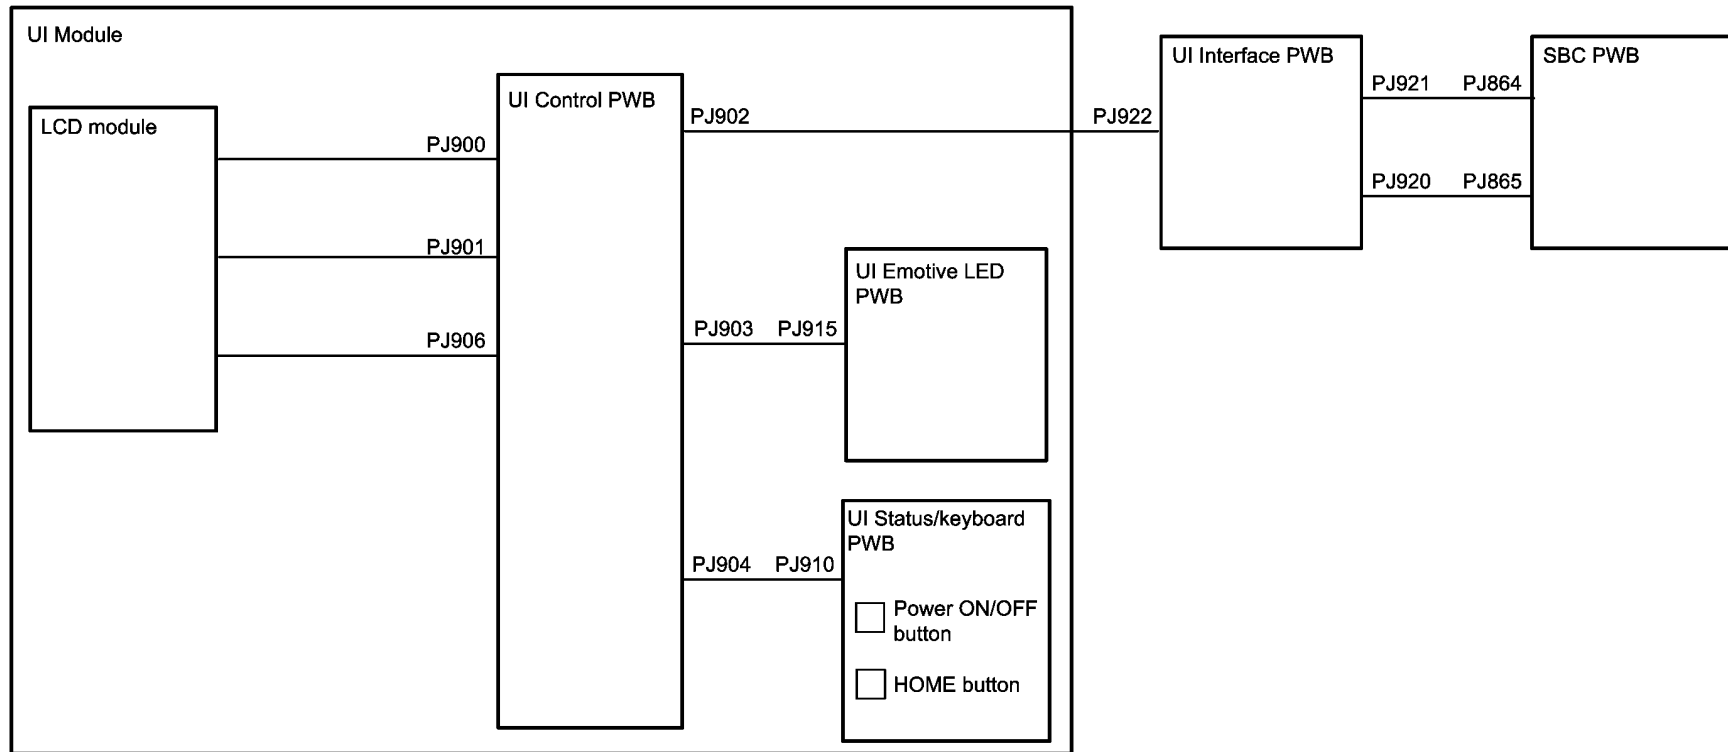
- UI module, [PL 2.10 Item 1](#).
- UI interface PWB, [PL 2.10 Item 15](#).

Figure 1 User interface components

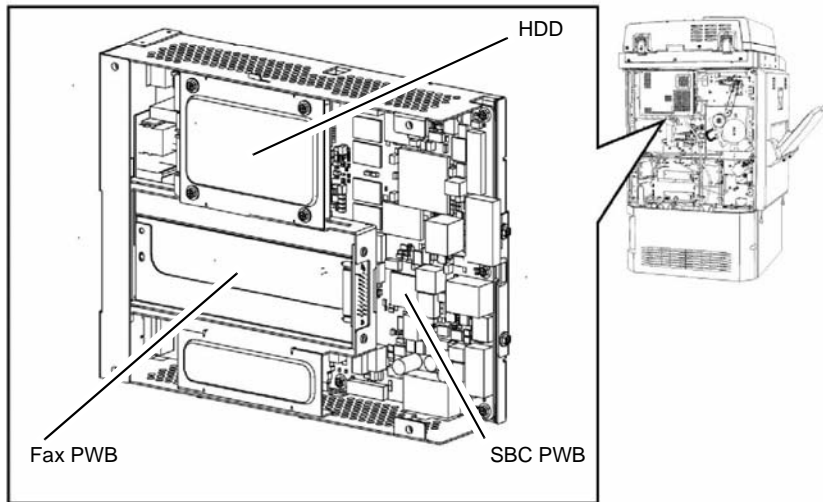
Refer to PL 3.22. The SBC PWB is contained in a chassis. The SBC PWB chassis consists of a metal cage, interior bracket, and top cover. The module contains the SBC PWB, HDD, and optionally, the fax module and FDI PWB, along with mechanical parts and harnesses. Refer to Figure 1 and Figure 2.

Figure 1 SBC PWB module

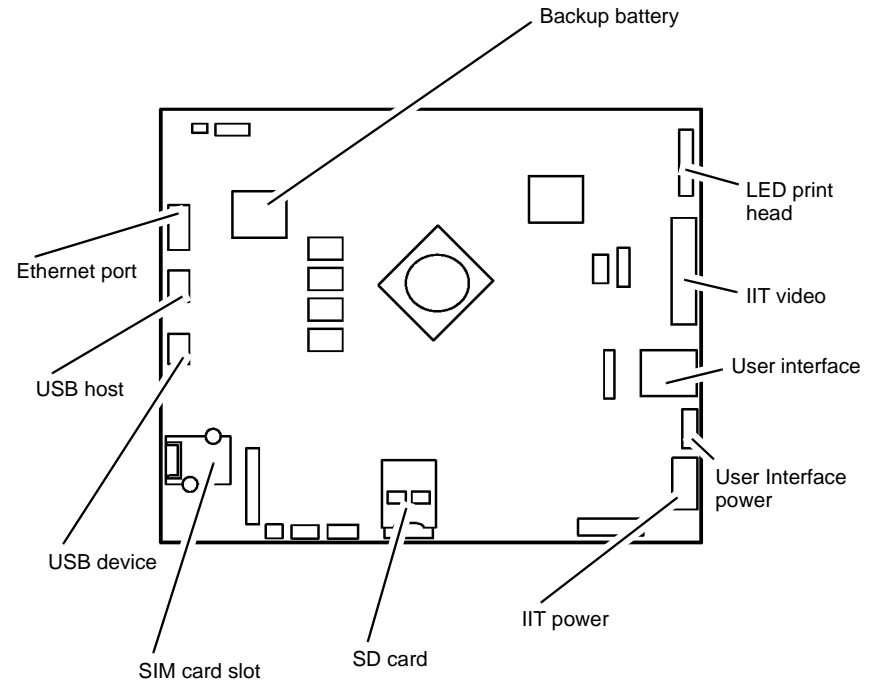
Figure 2 SBC PWB

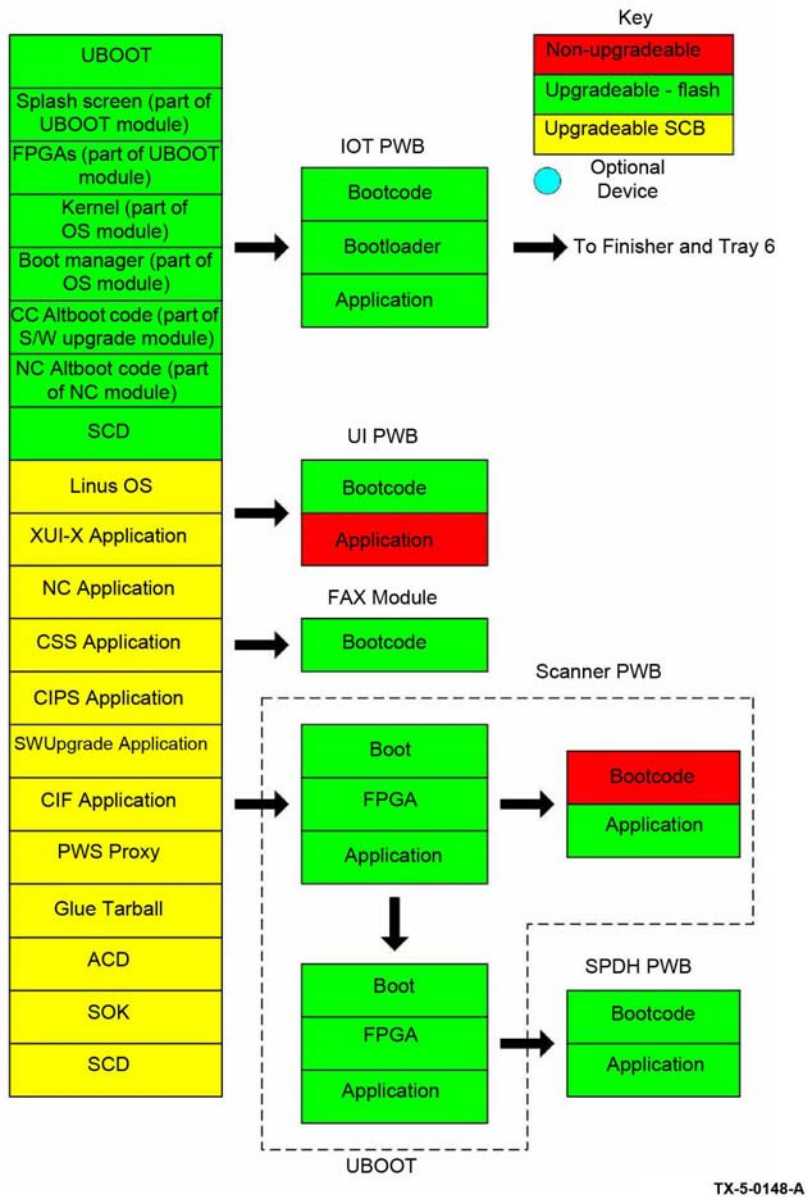
The IOT PWB is connected to the tray 6 control PWB. The IOT PWB receives software upgrades from the SBC PWB and sends software upgrades to the tray 6 control PWB. The IOT PWB receives version the number from the installed tray 6 module and sends the version number to the IOT PWB.

Figure 3 Software upgrade information (1 of 2)

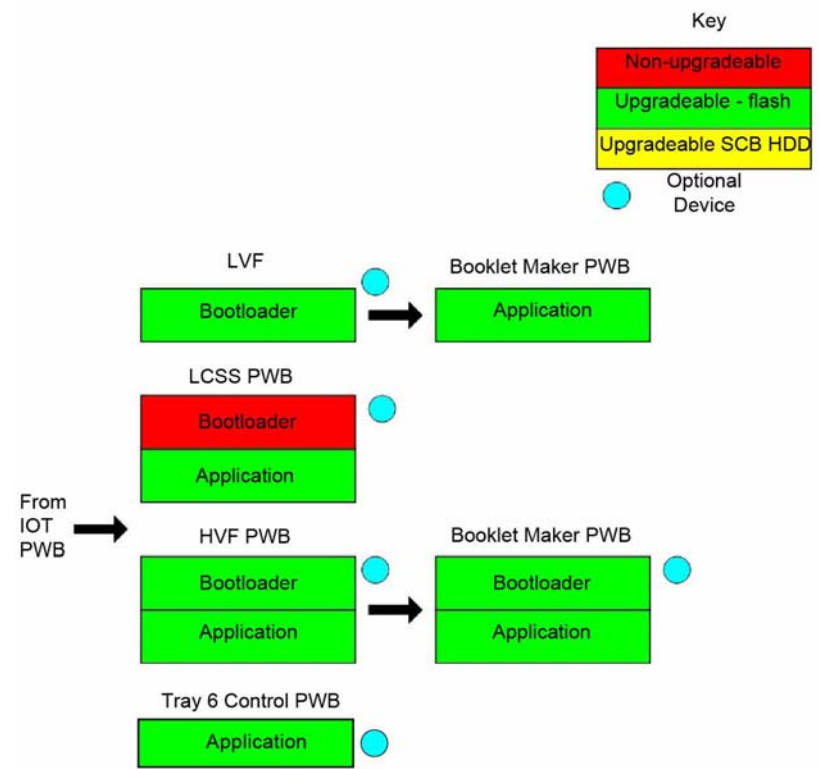
Figure 4 Software upgrade information (2 of 2)

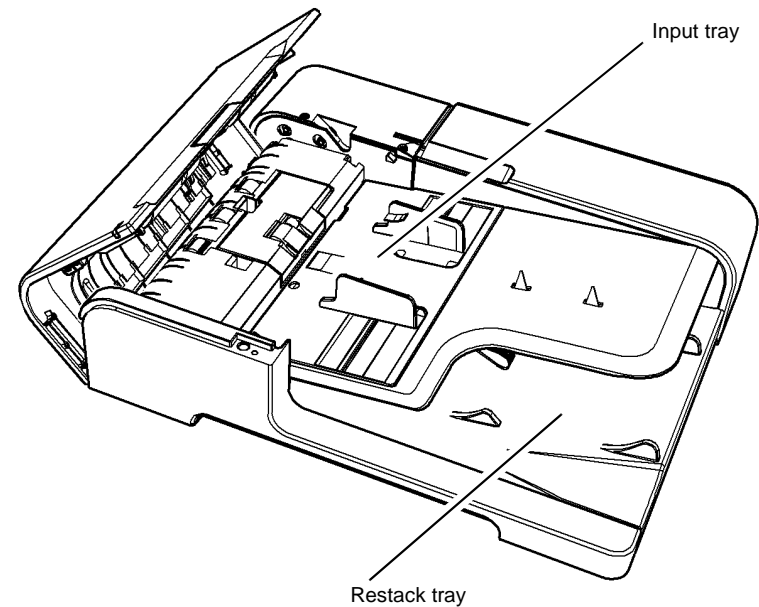
The SPDH is a center registered automatic document handler, that separates and feeds up to 200 (face up) original documents of 80gsm individually in 1 to N order. It is capable of scanning simplex (this mode scans only one side of a document set) and duplex (this mode scans both sides of a document set) documents. For simplex images the SPDH transports documents over the CVT window of the platen scanner. The document is then transported to the re-stack tray. For duplex images side 2 of the document is scanned via the side 2 scan assembly as the document is transported to the re-stack tray. The side 2 scan assembly is mounted internal to the SPDH. Document output to the re-stack tray will be in the same order as input (face down), [Figure 1](#).

Figure 1 SPDH

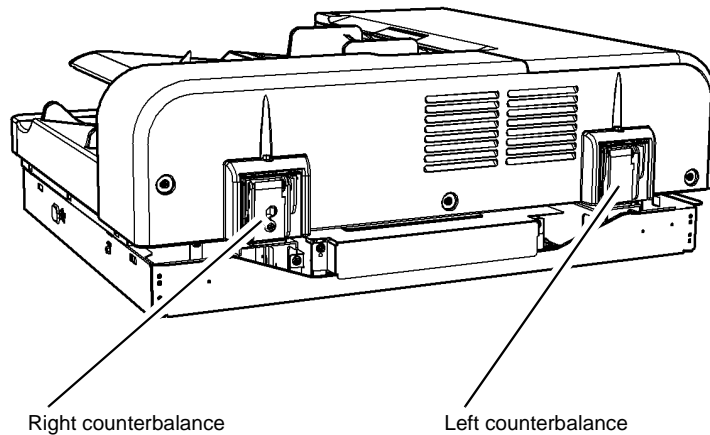
Two counterbalance assemblies, [Figure 2](#), secure the document handler to the scanner frame. A counterbalancing force is generated by compression springs acting on a cam-follower arrangement, all housed within sheet metal brackets. Above a set drop-down angle, the SPDH will hold or rise slowly to the maximum opening angle. Below the set drop-down angle, the SPDH will gently close onto the scanner. The right hand bracket provides a means of adjustment for document skew. In addition, the counterbalance assemblies are double-hinged to allow a customer to close the SPDH onto books of up to 25mm in thickness without applying excessive force to the document glass of the scanner. This feature is known as book-mode operation.

Figure 2 Counterbalances

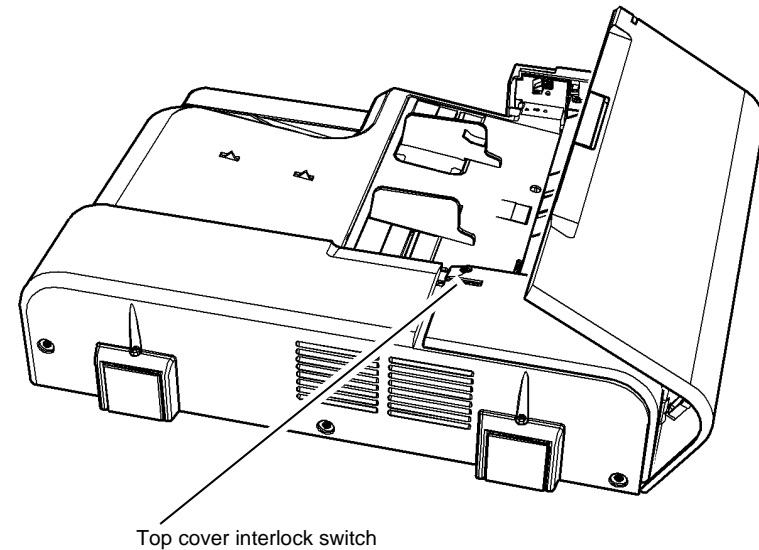
The SPDH top cover interlock switch, S05-305, [Figure 3](#), is located at the rear of the SPDH. S05-305 controls the +24V supply to all clutches, solenoids, motors and the side 2 scan assembly via the SPDH PWB. The SPDH top cover switch isolates the SPDH +24V circuit when the top cover assembly is opened. The interlock is used to ensure operator safety by removing power to the SPDH drives when not actuated. The scanner PWB supplies +3.3V, +5V, +12V and +24V to the SPDH PWBA. The SPDH PWB then controls the output of power to all the components in the SPDH.

Figure 3 Top cover interlock switch

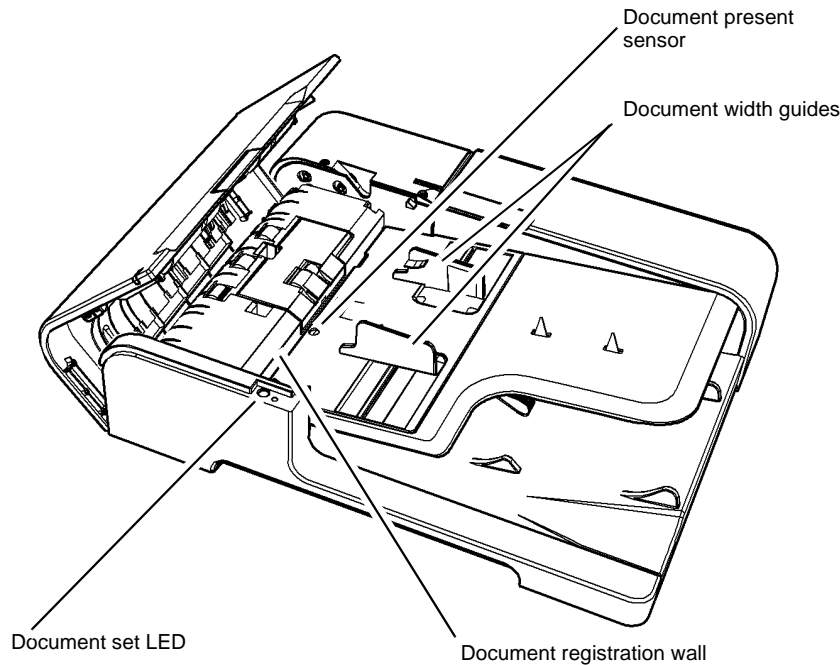
Copies are placed into the input tray face up, 1 to N order. The capacity of the input tray is 200 originals of 80gsm weight. The minimum size original is A5 (5.5 X 8.5 inch), SEF or LEF. The maximum size of original is A3 (11 X 17 inch), SEF only. Table 1 lists recognized paper sizes and orientations. Intermixed lengths (feed direction) are acceptable for a limited number of document pairs, which are described below in the Mixed Size Mode section. The tray will provide for center feeding in 1 to N sequence. Movable tray guides for the document width are provided. Correct guide adjustment by the operator is imperative for reliable feeding and auto paper select. The SPDH document present sensor (Q05-309), detects originals loaded against the document registration wall. When the SPDH document present sensor is actuated the document set LED (LP05-084), illuminates. Refer to Figure 4.

Figure 4 Input tray

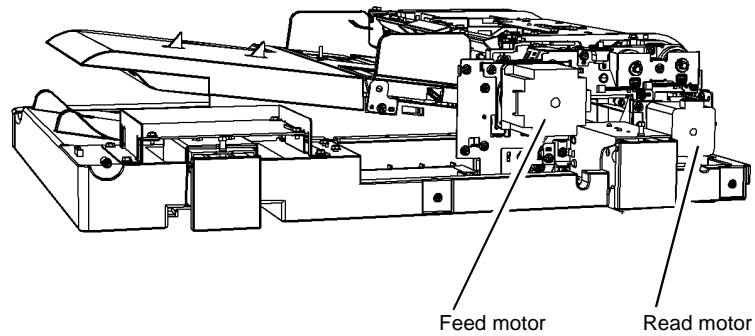
Three 24V motors provide the drive for the SPDH components, the feed motor and read motors are shown on [Figure 5](#), the Tray elevator motor is shown on [Figure 8](#).

Figure 5 Feed motor and read motor

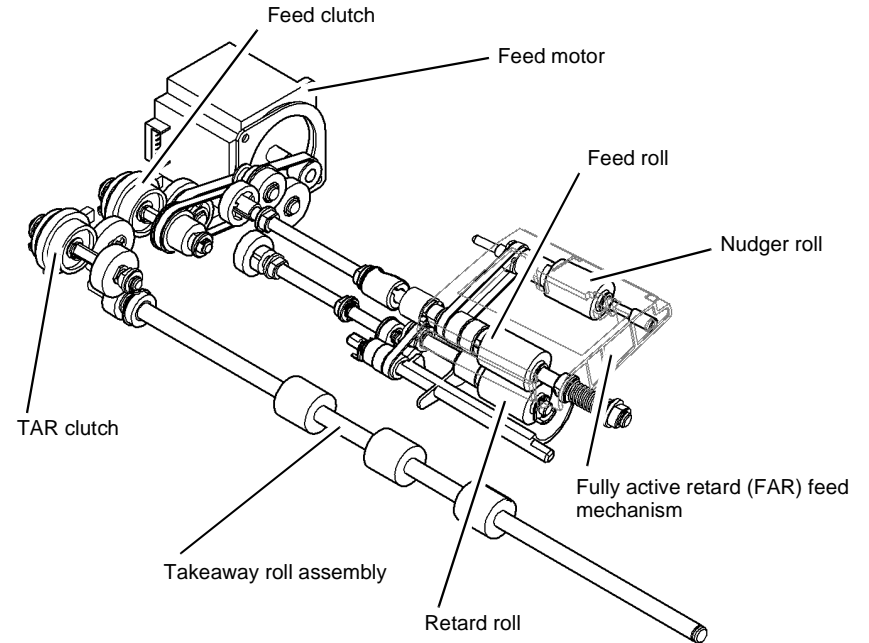
The feed motor ([PL 5.18 Item 2](#)) supplies continuous drive via a toothed belt and gears to both the takeaway roll clutch, CL05-425, and feed clutch, CL05-025, during the scan process of the document. The TAR clutch, when energized provides drive to the takeaway roll. The feed clutch when energized provides drive to the feed, nudger and retard rolls that form the fully active retard feed assembly, via their respective gear trains, [Figure 6](#).

Figure 6 Feed motor

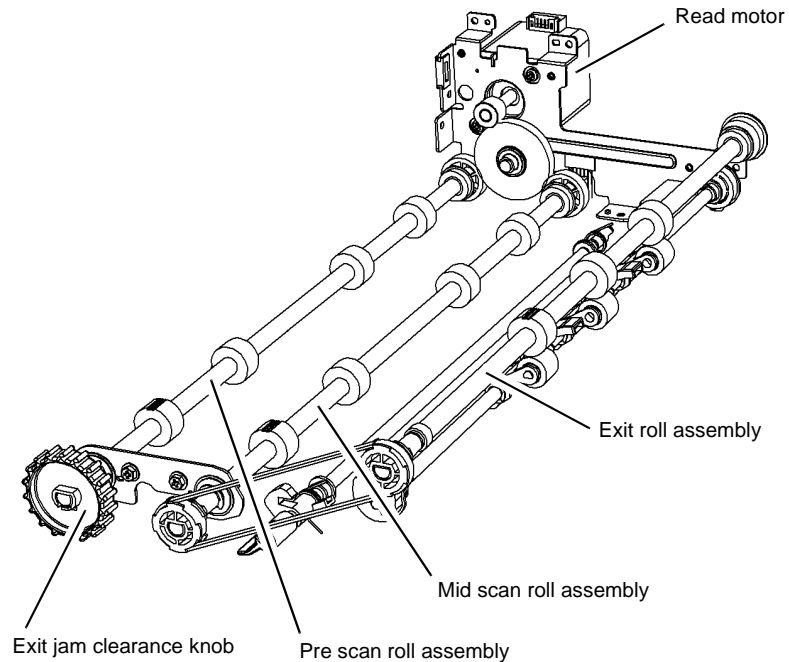
The read motor (PL 5.18 Item 1) supplies continuous drive to the pre scan roll assembly and mid scan roll assembly. The exit roll assembly is driven by a pulley and toothed belt arrangement from the mid scan roll, Figure 7. The read motor also provides the drive (when run in reverse) for the side 2 scan assembly calibration mechanism, shown in detail in Figure 16. The exit jam clearance knob (PL 5.17 Item 5), under the front left corner of the SPDH, can be used to clear jams and feed documents along the document path to activate sensors for diagnostics.

Figure 7 Read motor

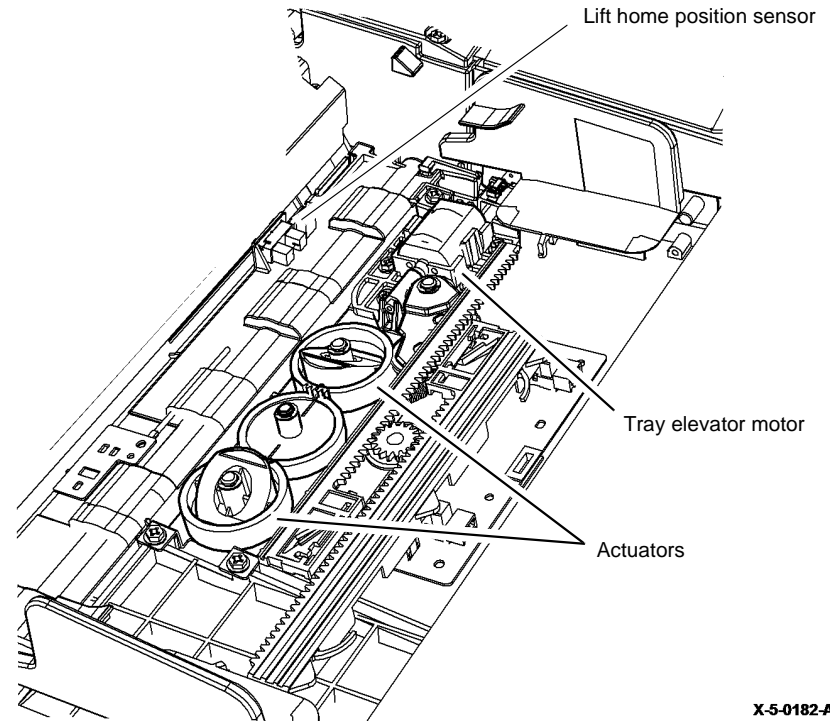
The lift home position (lowered) sensor, Q05-307, is a flag actuated sensor that senses the input tray is in the home position, Figure 8.

Figure 8 Tray elevator motor

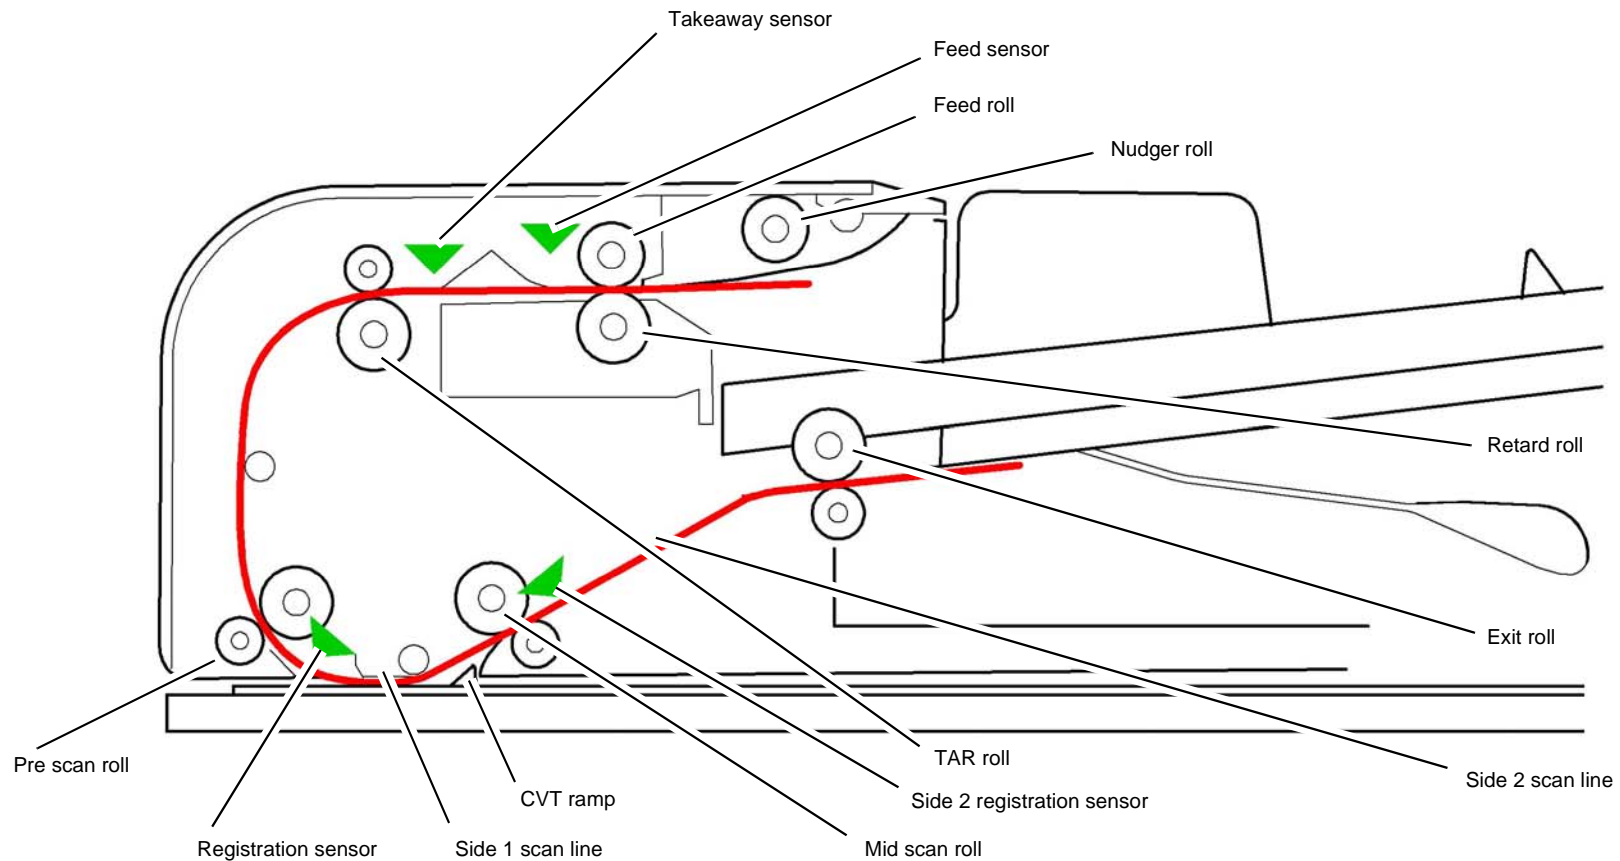
There are several sensors located throughout the document path to detect the position of the document. The signals from these sensors initiate operations within the SPDH, and also assist with jam detection, [Figure 9](#).

Figure 9 SPDH document path

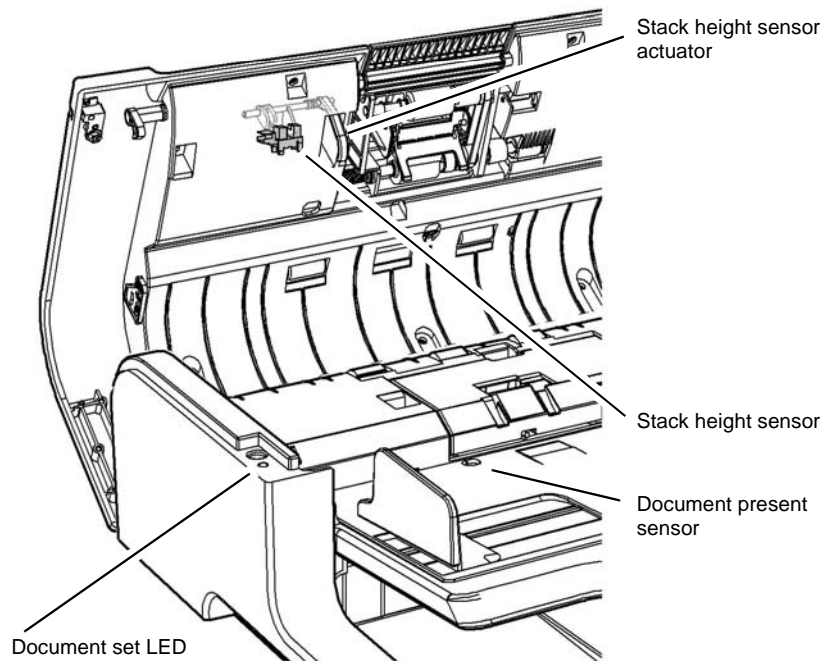
The stack height sensor, Q05-310 (PL 5.20 Item 4), is a flag actuated sensor that senses the paper stack and maintains the stack height by triggering activity of the tray elevator motor, Figure 10.

Figure 10 Paper stack sensors

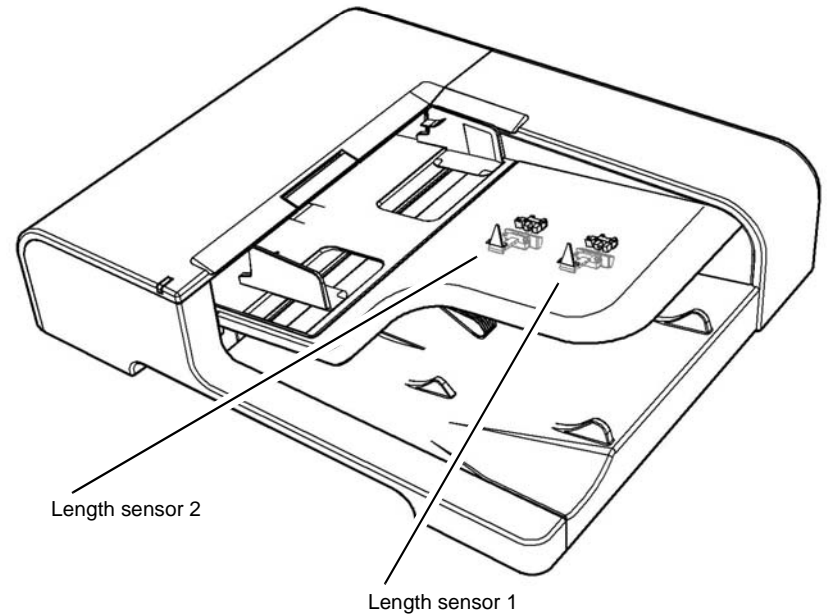
Length sensor 2, Q05-320 (PL 5.30 Item 5), is a flag actuated sensor that senses documents in the input tray longer than 240mm, Figure 11.

Figure 11 Length sensors

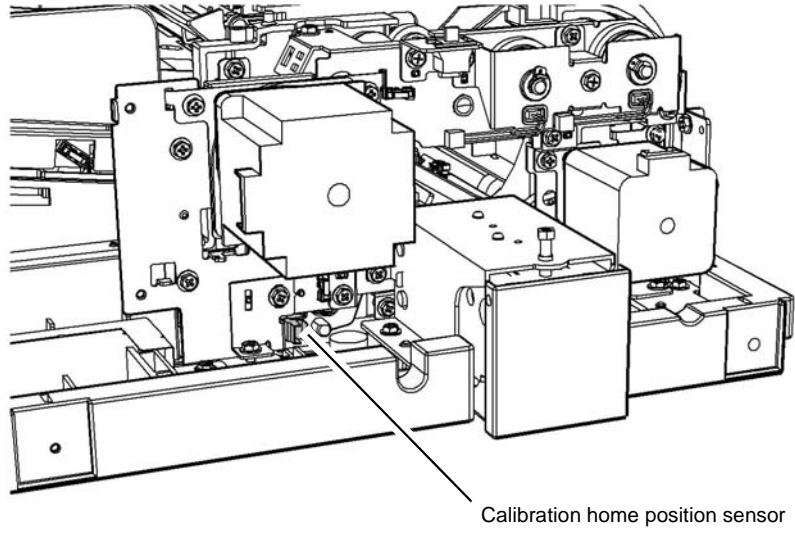
Figure 12 Calibration home position sensor

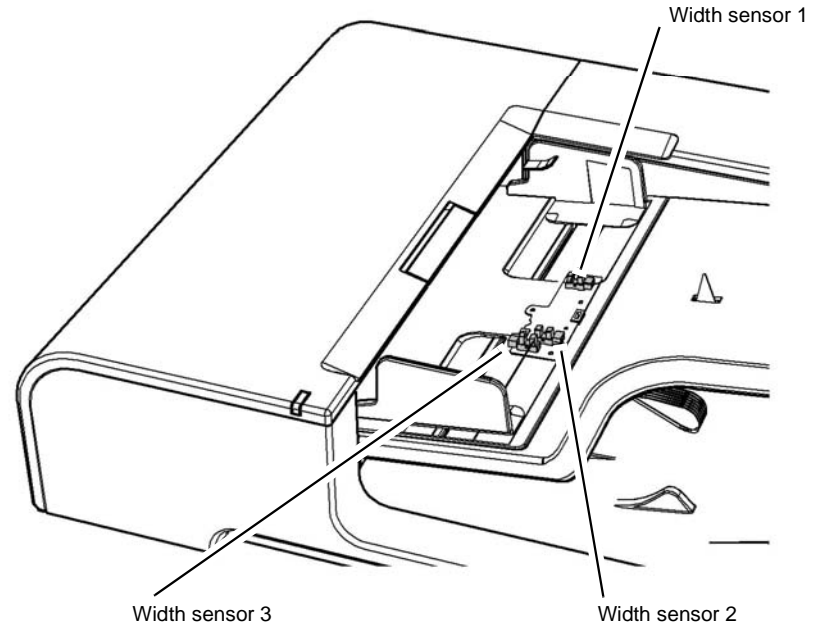
Width sensors (PL 5.30 Item 5) 1, Q05-325, 2, Q05-326, and 3, Q05-327, are actuated by flags attached to the document width guides of the input tray. The 3 width sensors are positioned to allow the detection of common document widths. Working with length sensors 1 and 2 they enable the machine software to determine various document sizes, Figure 13.

Figure 13 Width sensors

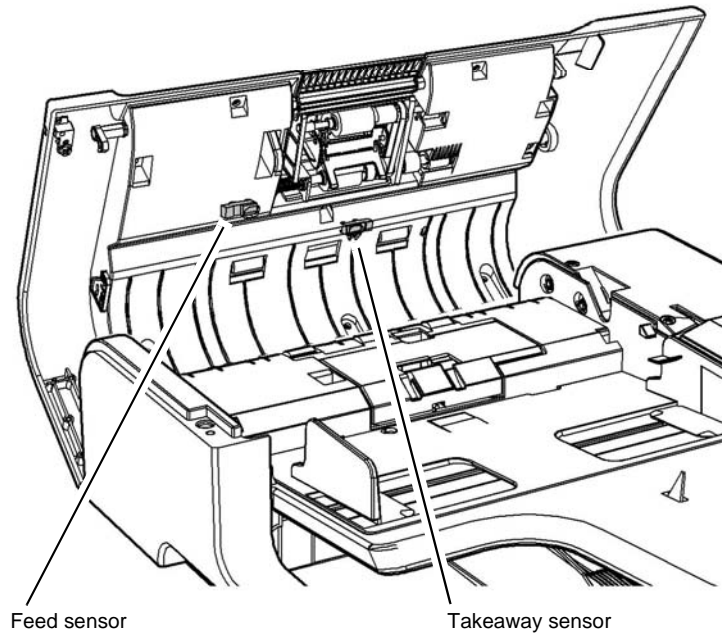
The takeaway sensor, Q05-335 (PL 5.20 Item 9), is a reflection activated sensor that senses the lead edge and trail edge of documents entering the takeaway roll assembly. This sensor triggers the stop of the separation nip and nudger rotation. This allows the takeaway roll assembly to pull the document through the separation nip to ensure an interdocument gap, Figure 14.

Figure 14 Feed and takeaway sensors

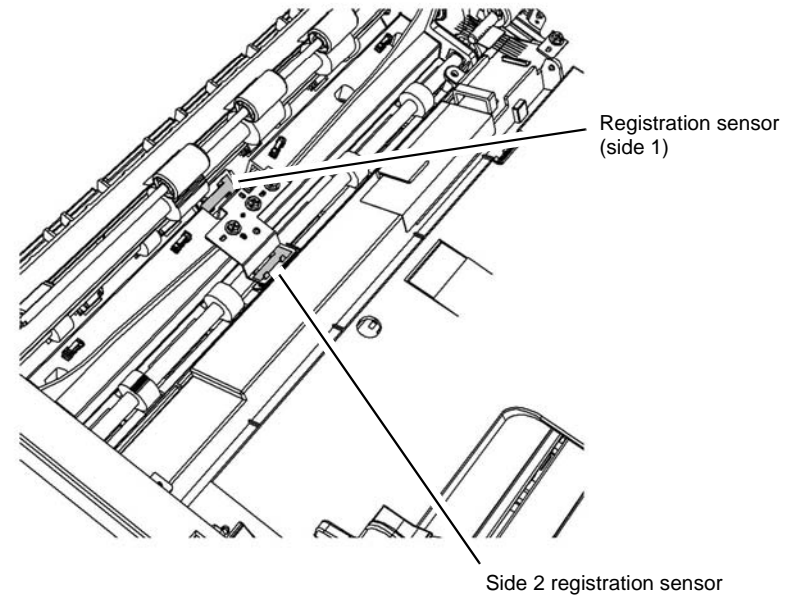
The side 2 registration sensor, Q05-343 (PL 5.18 Item 9), is a reflection activated sensor that senses the lead edge and trail edge of documents just prior to the side 2 scan area, Figure 15.

Figure 15 Registration sensors
