708P91368
September 2017

Xerox® AltaLink® B8090 Family Multifunction Printer Service Manual

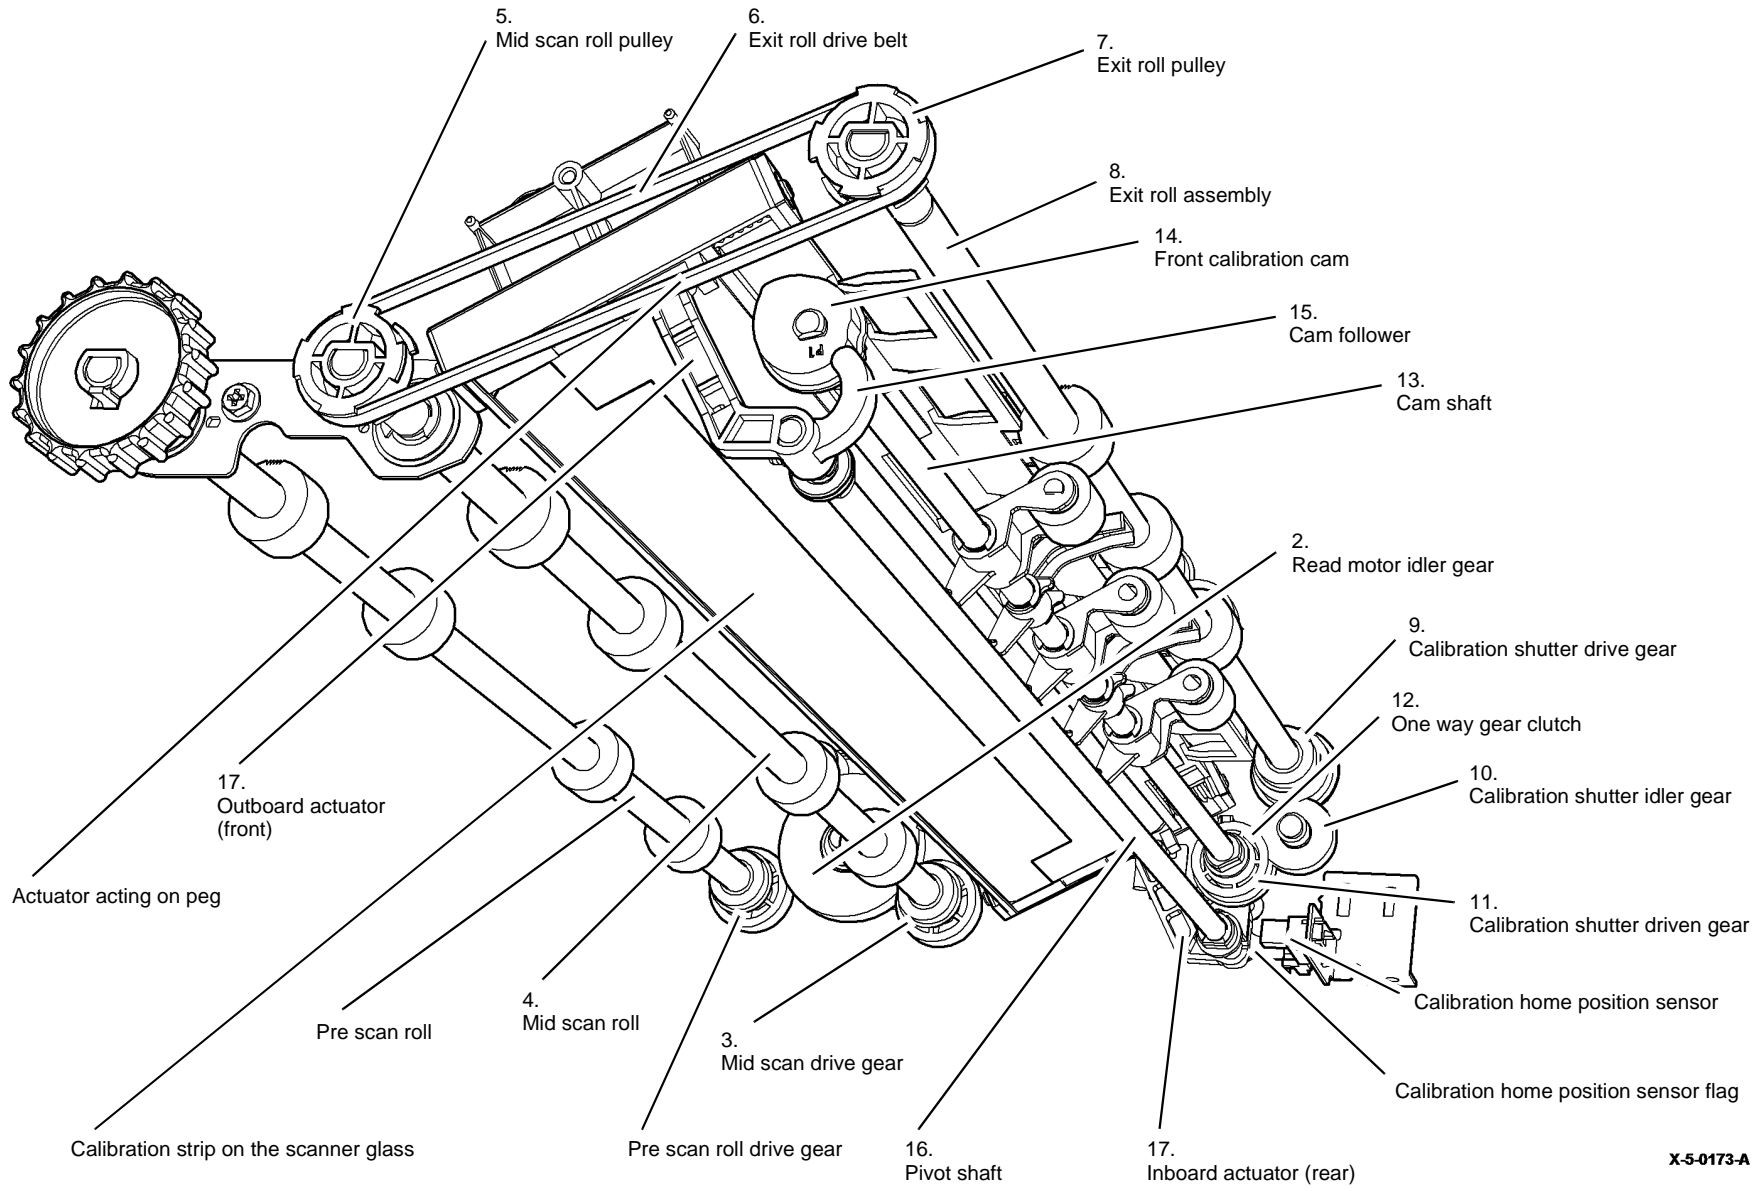
The drive train for the side 2 scan assembly calibration mechanism is as follows (refer to [Figure 16](#)):

1. Read motor, [PL 5.18 Item 1](#)(not shown).
2. Read motor idler gear, [PL 5.19 Item 16](#).
3. Mid scan drive gear, [PL 5.19 Item 12](#).
4. Mid scan roll, [PL 5.17 Item 3](#).
5. Mid scan roll pulley [PL 5.19 Item 18](#).
6. Exit roll drive belt, [PL 5.19 Item 19](#).
7. Exit roll pulley, [PL 5.19 Item 21](#).
8. Exit roll assembly, [PL 5.17 Item 2](#).
9. Calibration shutter drive gear, [PL 5.19 Item 8](#).
10. Calibration shutter idler gear, [PL 5.19 Item 6](#).
11. Calibration shutter driven gear, [PL 5.19 Item 7](#).
12. One way gear clutch.
13. Cam shaft
14. Front calibration cam, [PL 5.19 Item 20](#).
15. Cam follower
16. Pivot shaft.
17. Outboard (front) actuator and inboard (rear) actuator.

Figure 16 SPDH scanner calibration

As the cams rotate they push against followers at either end of a pivot shaft that move a pair of actuators. The inboard and outboard actuators push against pegs attached to the scanner glass. The action of the actuators on the pegs cause the glass to slide in the scan process direction, positioning the calibration strip directly under the scan line of the side 2 scan assembly. Once the calibration strip is in this position the calibration process takes place.

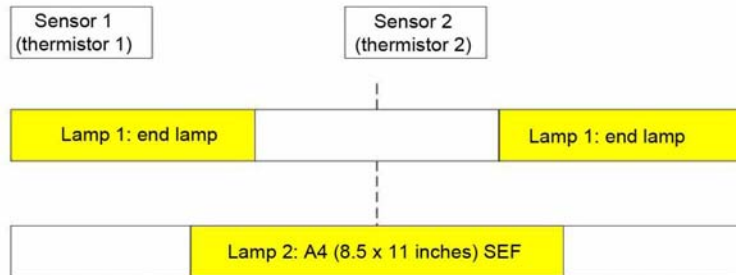
The temperature sensors are contact thermistors having a known value of resistance that varies with temperature. There are two temperature sensors in the fuser. One is located at the center of the heat roller, the other is located toward the front of the heat roller. Both thermistors monitor the temperature of the heat roller. Refer to [Figure 1](#).

Figure 1 Lamps and temperature sensors layout

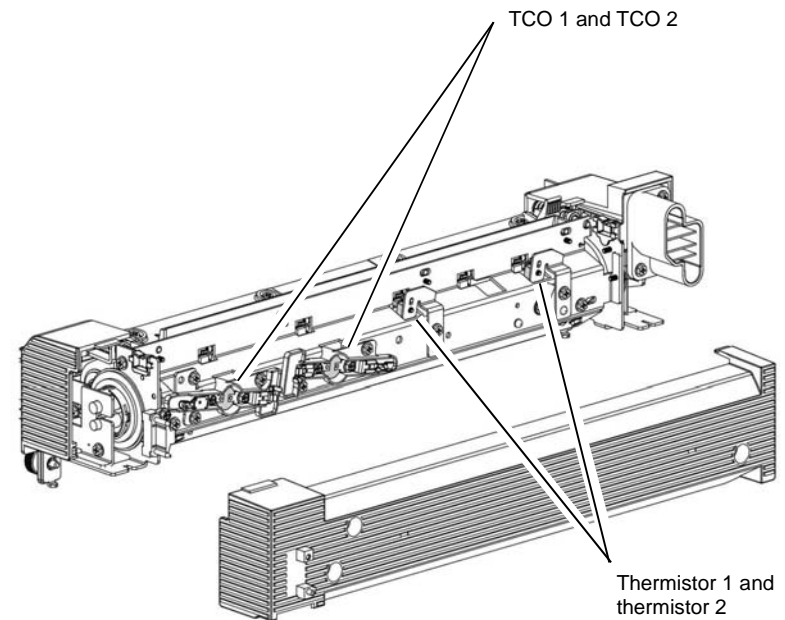
When the TCO blows power to the lamps is cut preventing damage to the module. If a TCO blows a new fuser module must be installed. Refer to [Figure 2](#).

Figure 2 TCOs and thermistors

- In a case where the temperature control system fails to operate correctly the TCO will blow when the temperature at the thermistor is 227 degrees C.
- There is a temperature differentiation between the thermistor and the fuser due to the air gap between the two.
- When the thermistor detects 227 degrees C the temperature at the fuser roll will be approximately 272 degrees C.

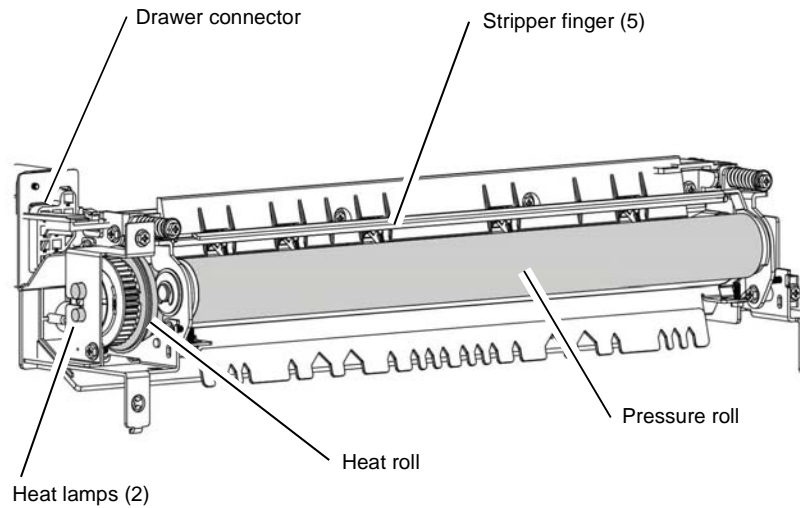
Five stripper fingers are kept in light contact with the fuser roll by spring tension. These prevent paper from remaining attached to the fuser roll. Refer to [Figure 3](#).

Figure 3 Fuser components

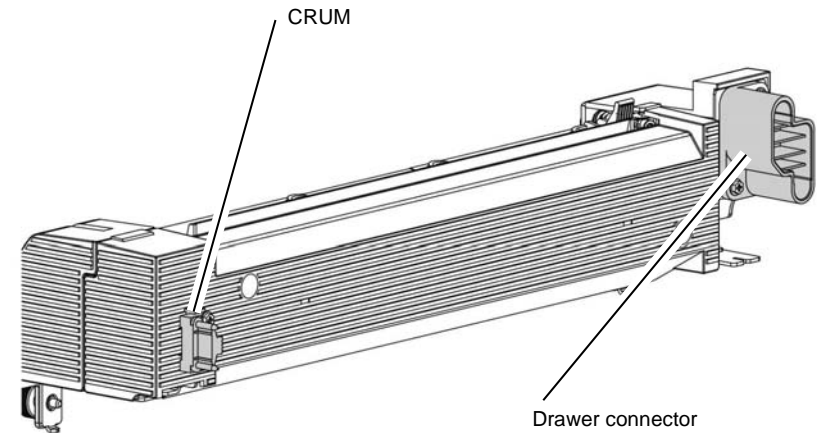
The CRU monitor (CRUM) is used to identify the type and age of the fuser module. It also identifies the market region and stores the print count. It also acts as an interlock. If the machine senses that the CRUM is disconnected, the machine will not run. Refer to [Figure 4](#).

Figure 4 CRUM and drawer connector

The drawer connector (Figure 4) provides the interface to the power and control for the fuser. Refer to Figure 5 for pin number locations on the fuser side, PJ100:

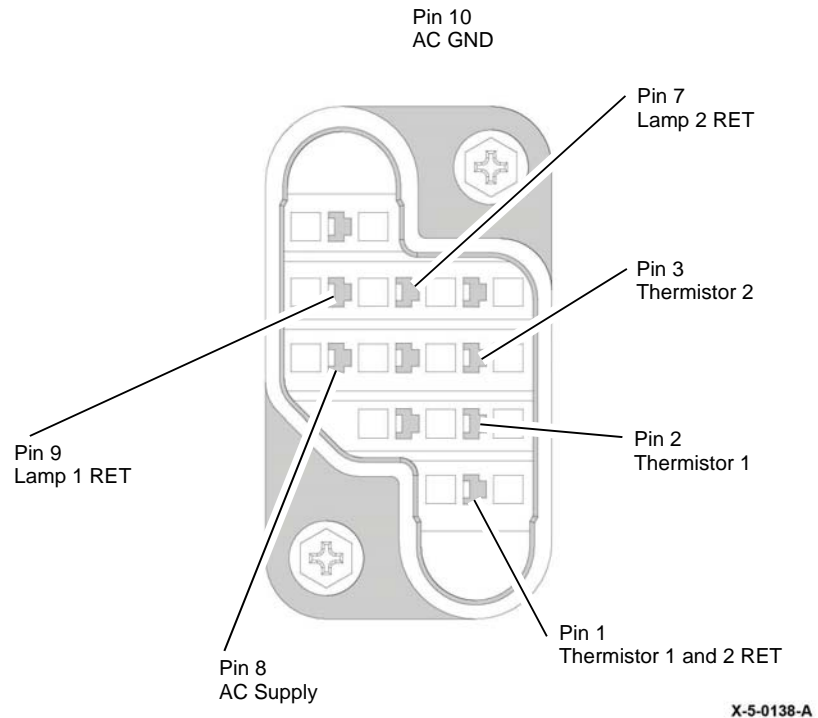
- Pin 1 thermistor 1 and thermistor 2 RET.
- Pin 2: thermistor 1.
- Pin 3: thermistor 2.
- Pin 7: lamp 2 RET (A4 SEF).
- Pin 8: AC Supply.
- Pin 9: lamp 1 RET (A4 LEF).
- Pin 10: AC GND.

Figure 5 Fuser drawer connector pins

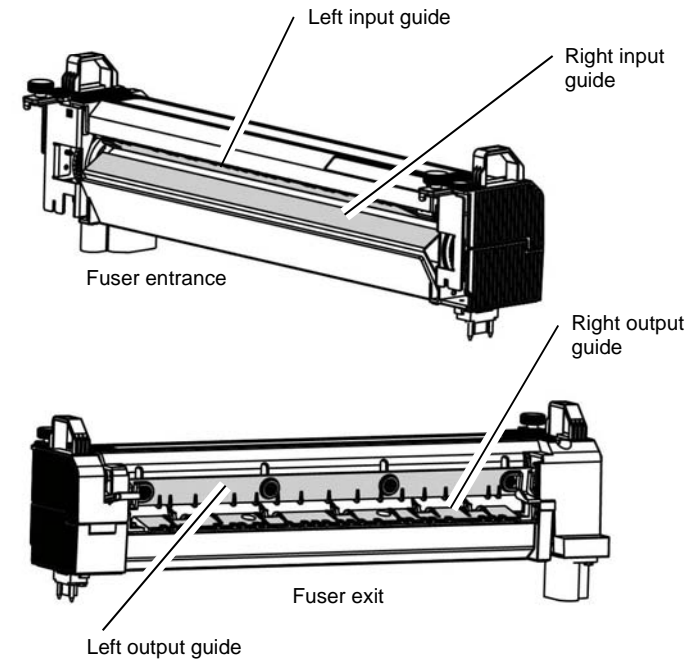
Refer to Figure 6. The fuser has the following paper guides:

- Left input guide. This guides the paper into the fuser.
- Right input guide. The right input guide is flocked and has the dual function of assisting with the alignment of the media on fuser entry and preventing an operator from gaining access to the hot fuser roll. In addition, it helps guide the paper into the fuser, ensuring that the lead edge contacts the fuser roll first.
- Left output guide. This guide hinges open to aid jam clearance.
- Right output guide. This guides the paper to the post fuser transport roller. The stripper fingers are mounted to this guide.

Figure 6 Fuser guides

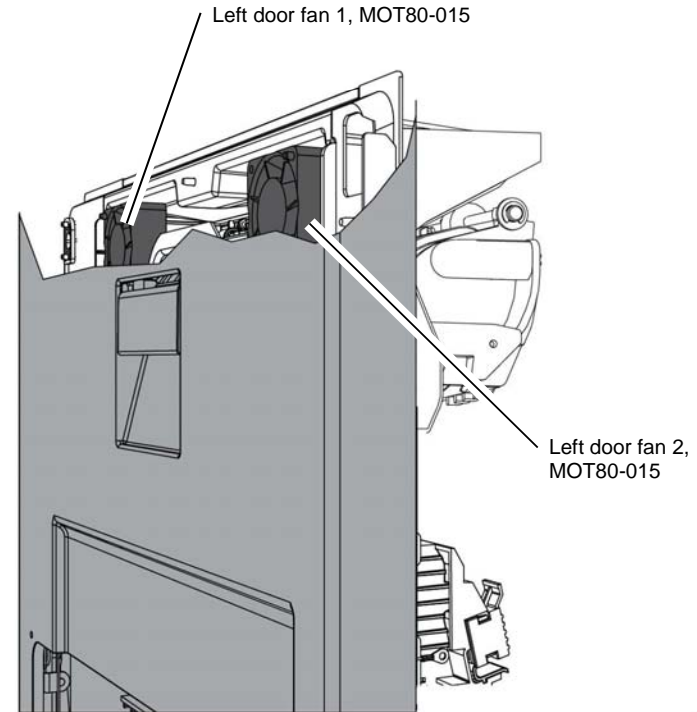
Two fans, MOT80-015 (PL 80.11 Item 9), mounted in the left door assembly provide cooling for the fuser and remove hot air from the xerographic subsystem. Refer to [Figure 7](#) and [Figure 8](#).

Figure 7 Cooling fans in left door assembly

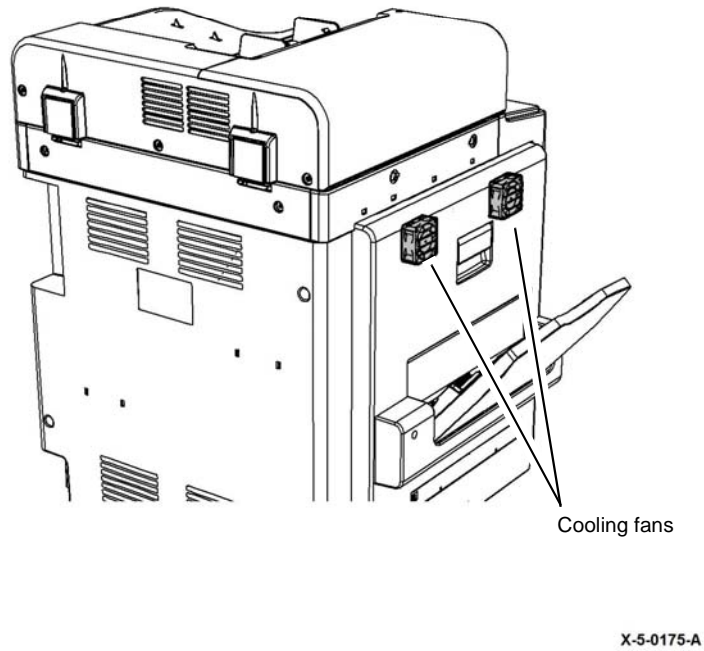
Figure 8 Cooling fans in left door assembly

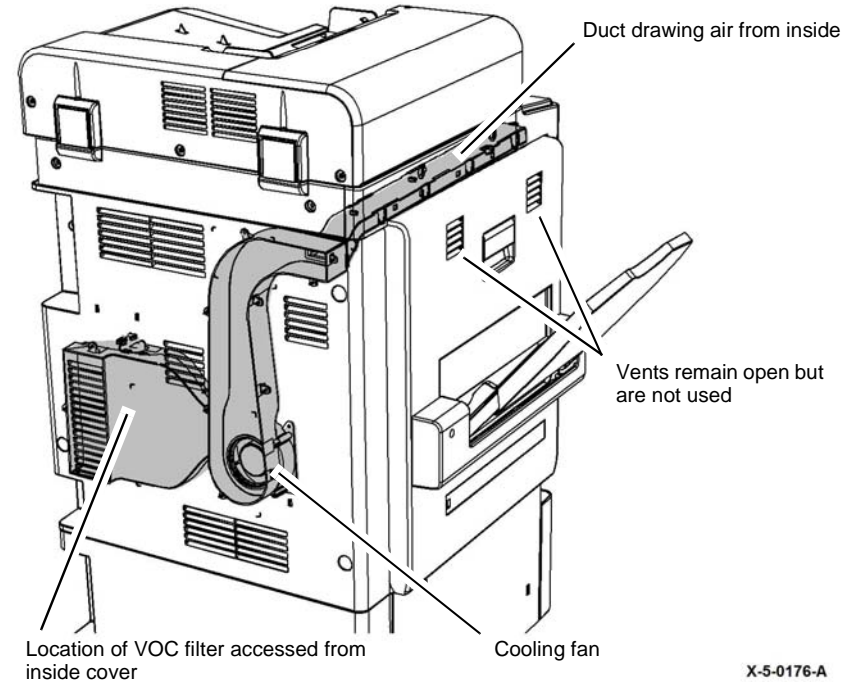
The higher speed variants do not have fans in the left door. A duct along the top of the left frame member extracts heat from the machine and connects to a duct utilizing a single large fan inside the rear cover, [Figure 9](#).

Figure 9 Cooling duct and fan 65/75/90 machines

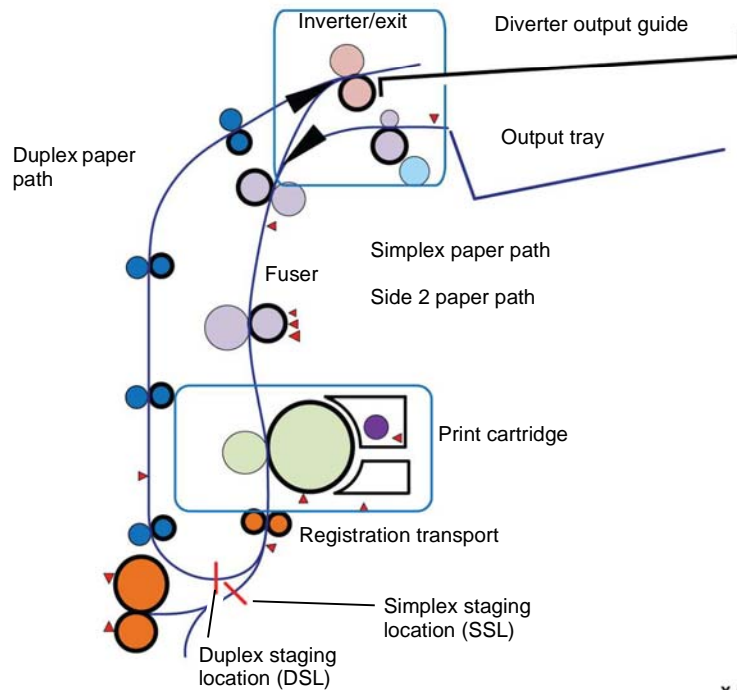
1. A sheet is received from a paper tray.
2. The sheet is transported from the registration transport to the xerographic module.
3. The sheet is received from xerographic module and transported to the fuser module.
4. The sheet is received from the fuser module.

5. The sheet is output:
 - to the horizontal transport and then to the finisher.
 - inverted sheets to the duplex path.
6. The sheet is re-registered at the registration rolls.
7. The sheet is transported to the xerographic module for duplex printing.
8. The sheet is received from xerographic module and transported to the fuser module.
9. The sheet is received from the fuser module.
10. The 2-sided sheet is output to the horizontal transport, then to the finisher.

Figure 10 Copy/print transport with output tray

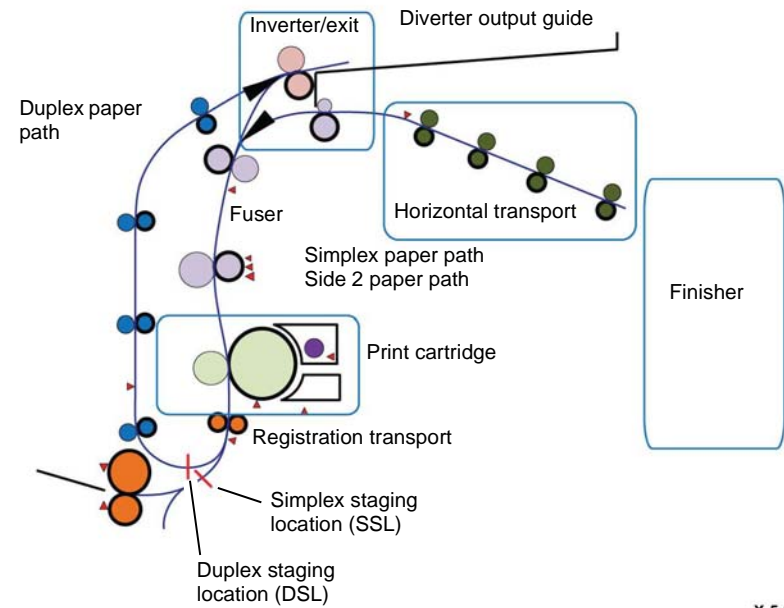
X-5-0141-A

Figure 11 Paper path with horizontal transport

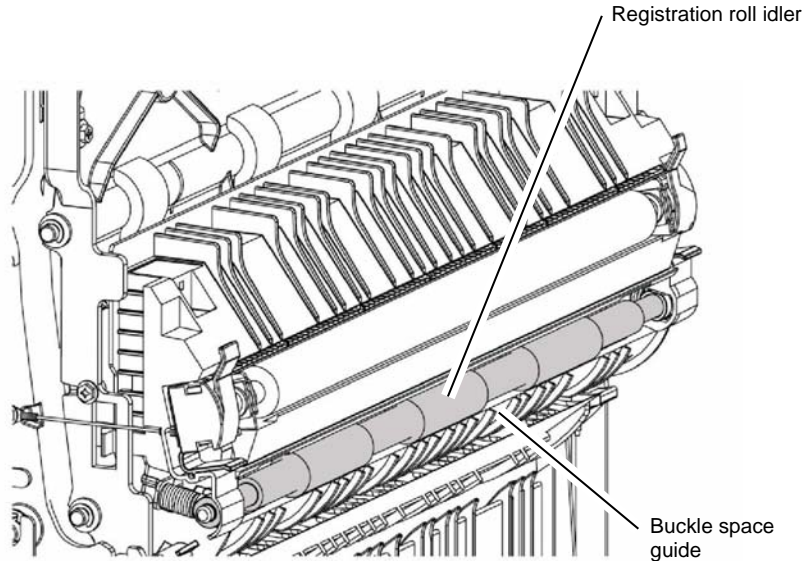
X-5-0142-A

For sheets coming from the duplex transport, the duplex motor continues to run. As the duplex nips push the sheet forward, the sheet is forced to buckle against the stationary registration nip. If the sheet is skewed, the buckle becomes differential in the cross-process direction resulting in the lead edge of the sheet orientating itself square against the registration nip. The deskewing processes for the simplex and duplex sheets are similar but use different nips and buckling spaces.

The time the buckling lasts is a parameter controlled by the IOT PWB. For simplex and duplex, the registration sensor signal is used as a trigger to start a timer. When the timer has expired, the registration motor is energized and the sheet is transported to the xerographic subsystem.

Figure 12 Registration transport

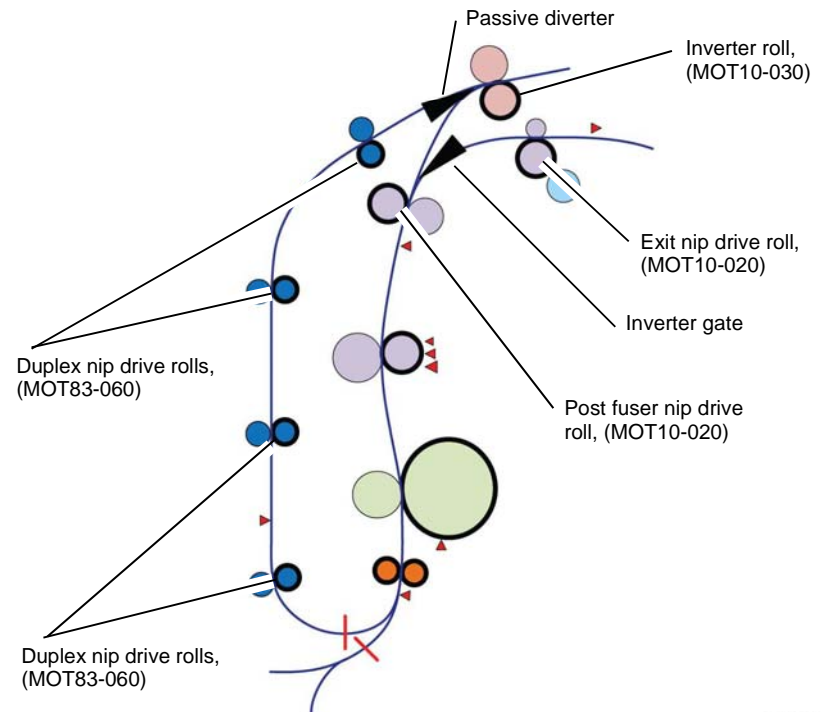
The inverter function is provided by an inverter roll that rotates in the forward direction and the reverse direction. The inverter gate guides the sheet to the inverter after the post fuser nip.

Figure 13 Inverter and duplex paper path

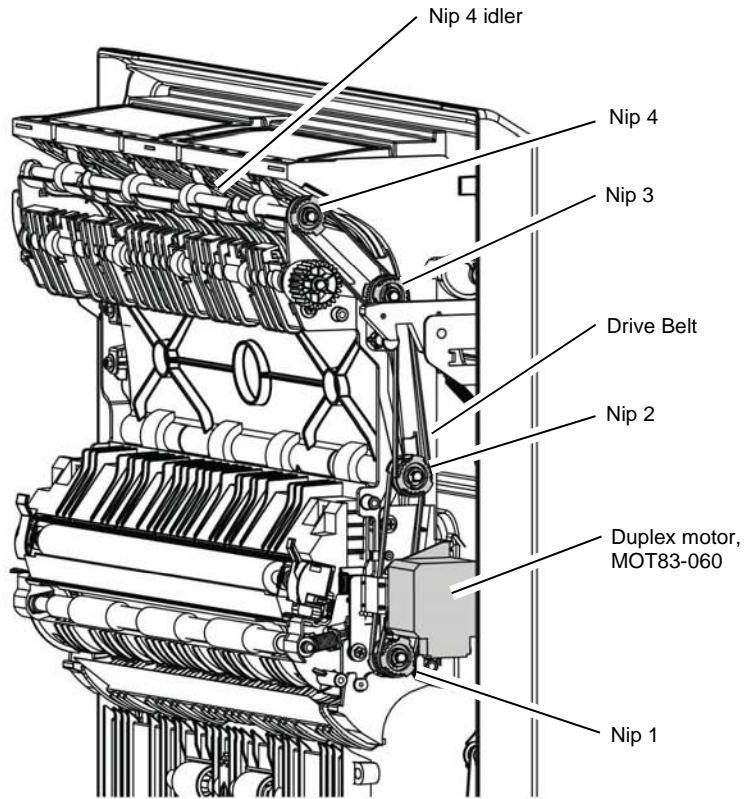
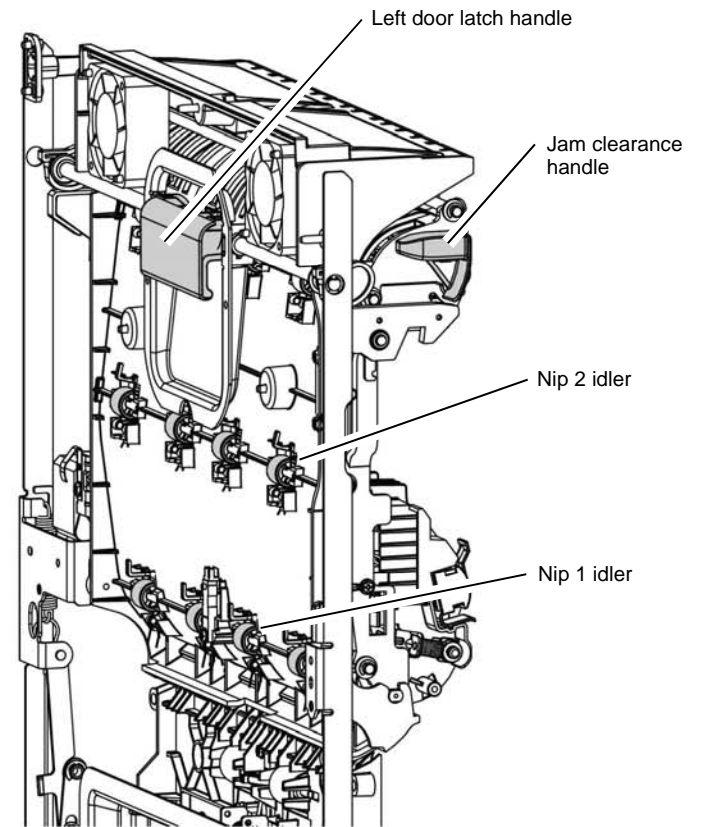
X-5-0144-A

Refer to [Figure 14](#). The duplex motor, MOT83-060 is a 4-phase stepper motor used to rotate 4 sets of duplex paper path rolls within the duplex transport. The duplex transport is located in the left door assembly. The duplex motor runs at duplex speed to transport the lead edge of the sheet from the inverter to the duplex staging location (DSL). The speed of the motor is controlled by the IOT PWB.

Figure 14 Duplex transport

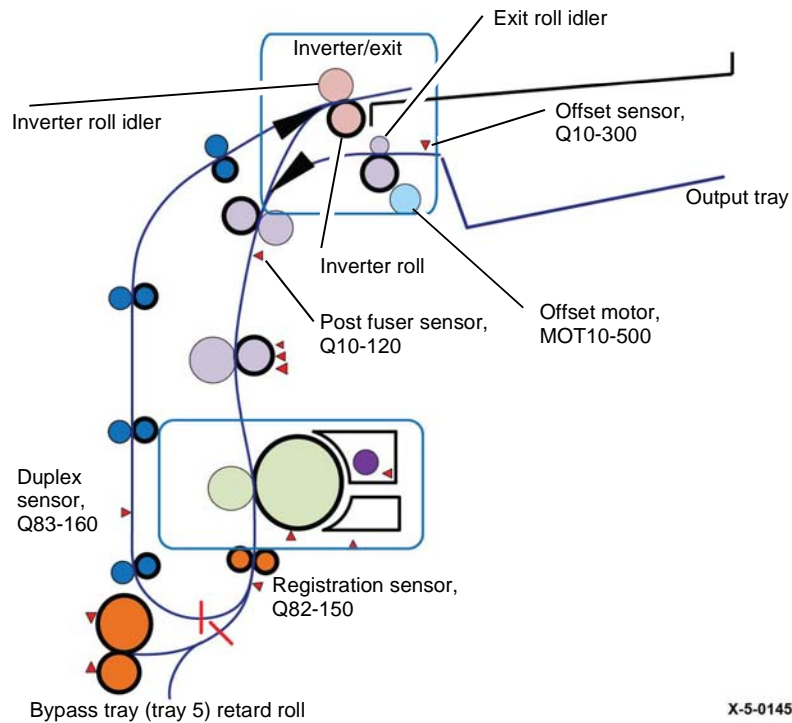
X-5-0145-A

Figure 15 Paper path with output tray

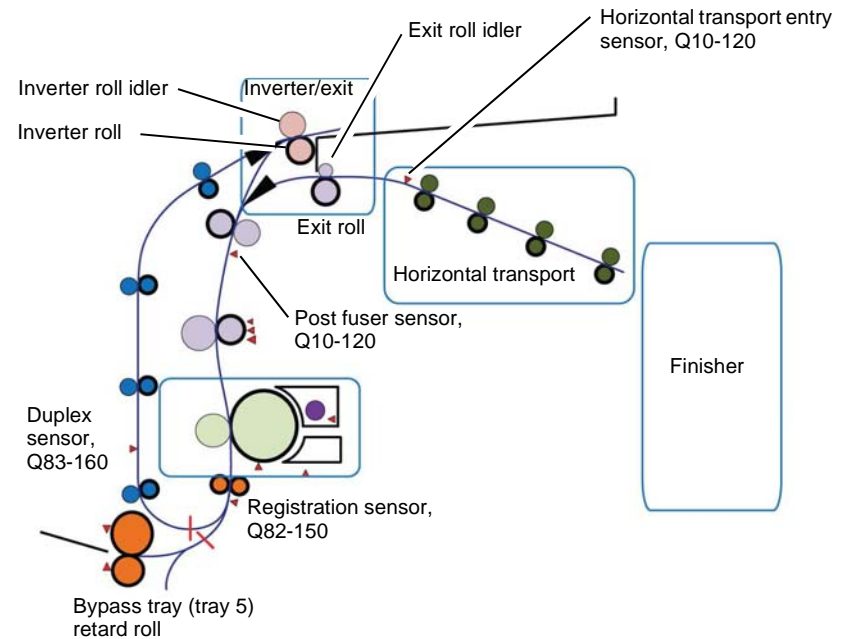
X-5-0146-A

Figure 16 Paper path with horizontal transport

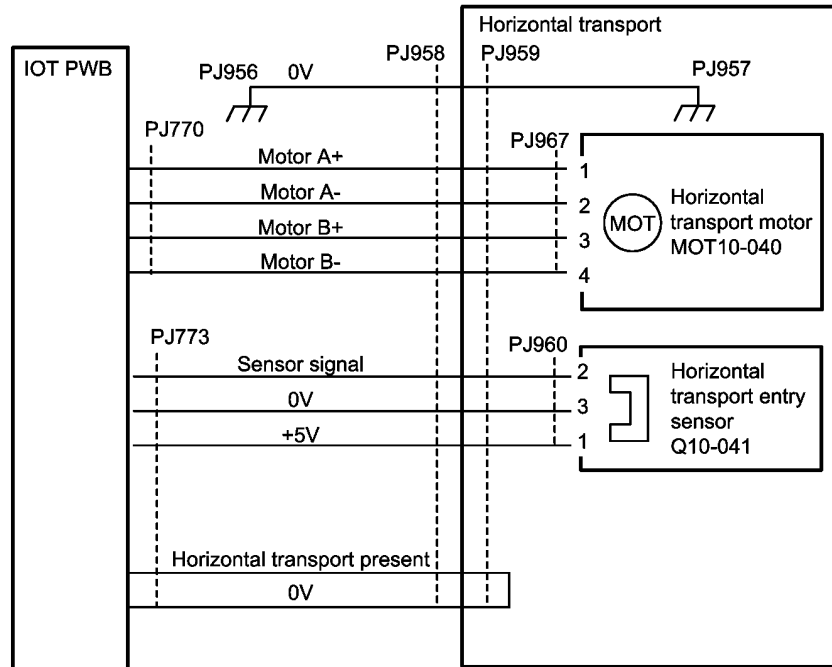
TX-5-0174-A

Refer to Figure 17. The electrical components in the horizontal transport are:

- Horizontal transport motor, MOT10-040 (PL 10.16 Item 1).
- Horizontal transport entry sensor, Q10-041 (PL 10.15 Item 7).

Figure 17 Circuit diagram

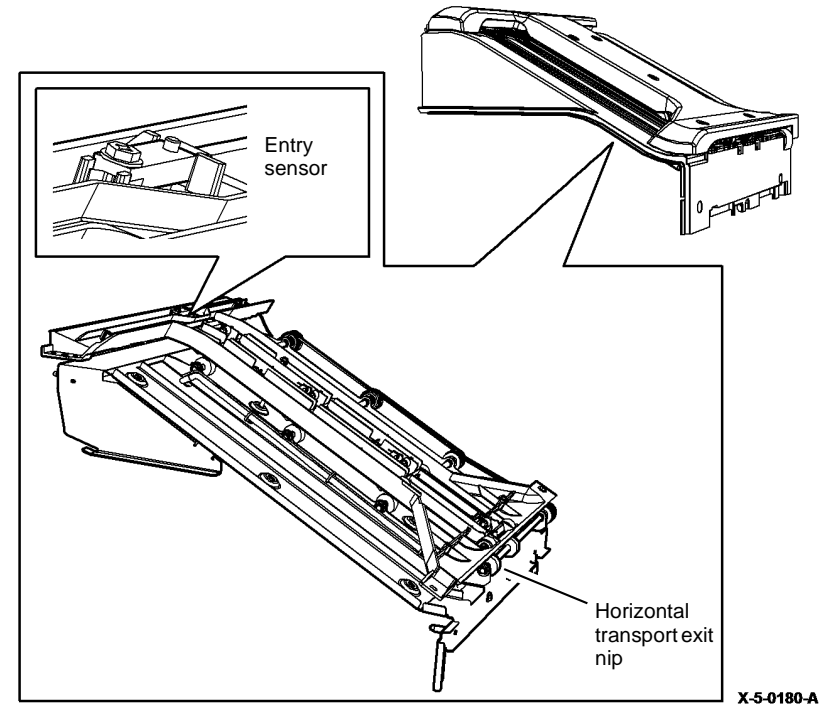
Figure 18 Horizontal transport module front view

Refer to Figure 18 and Figure 19 for details of components in the horizontal transport.

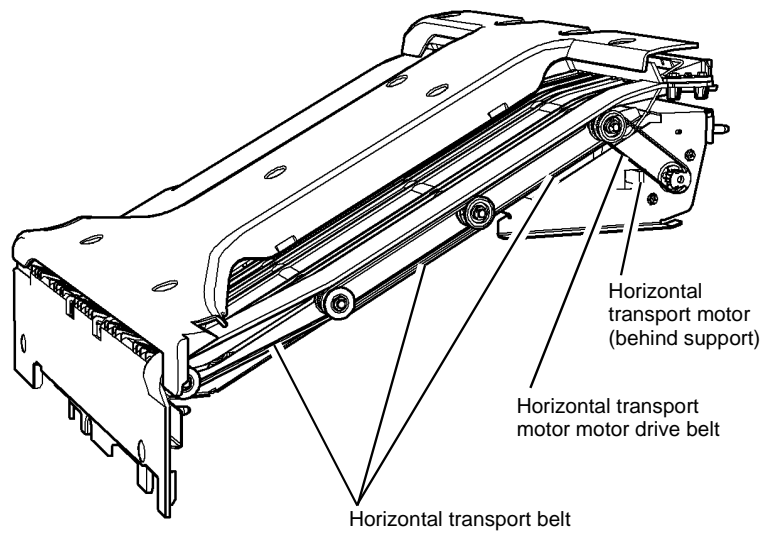
X-5-0181-A

Figure 19 Horizontal transport module rear view

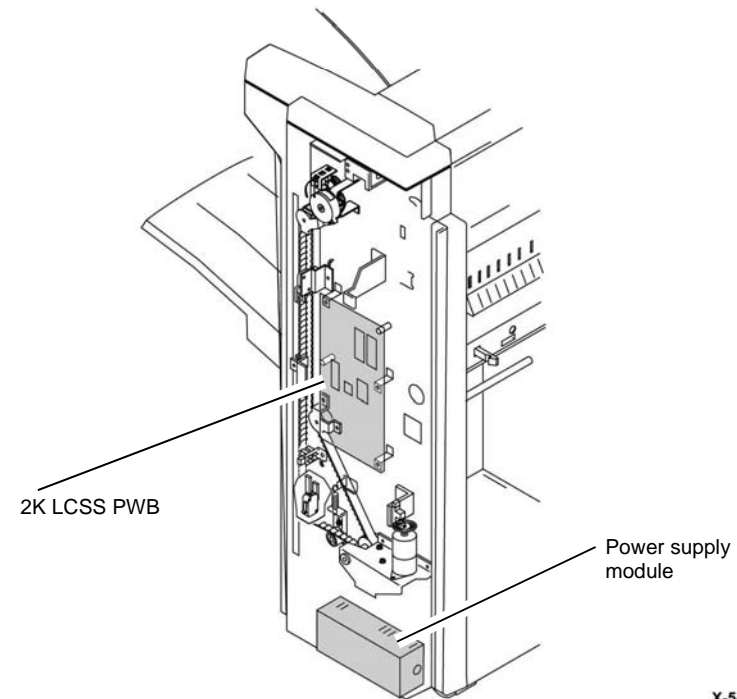
X-5-0032-A

Figure 1 Power supply module and 2K LCSS PWB

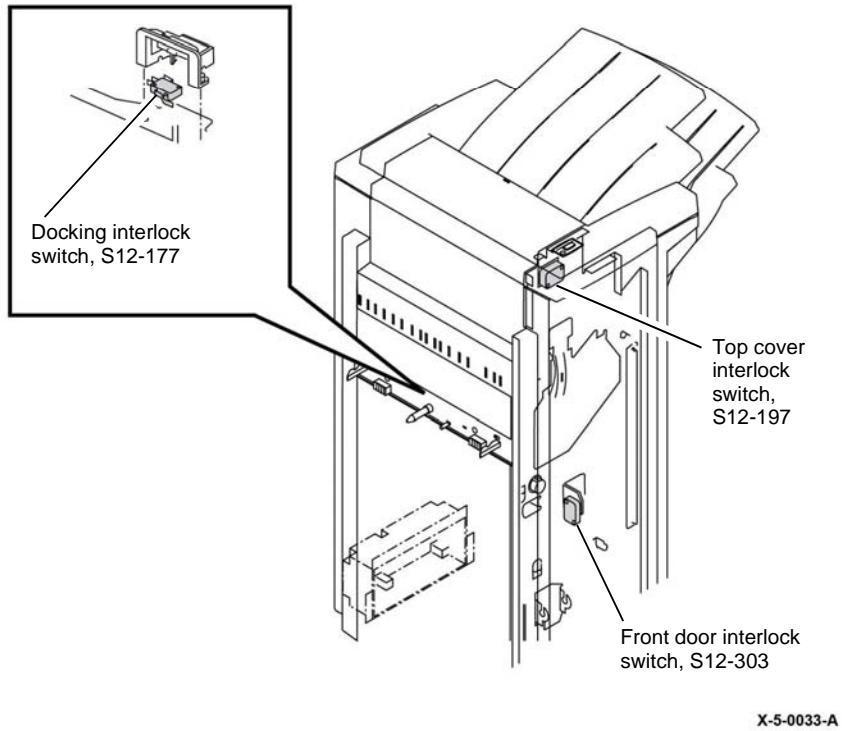
Refer to [Figure 2](#). Interlock switches in the 2K LCSS interrupt +24V power when either of the following are open during jam clearance or service:

- Front door interlock switch, S12-303
- Top cover interlock switch, S12-197

Figure 2 2K LCSS interlock switches

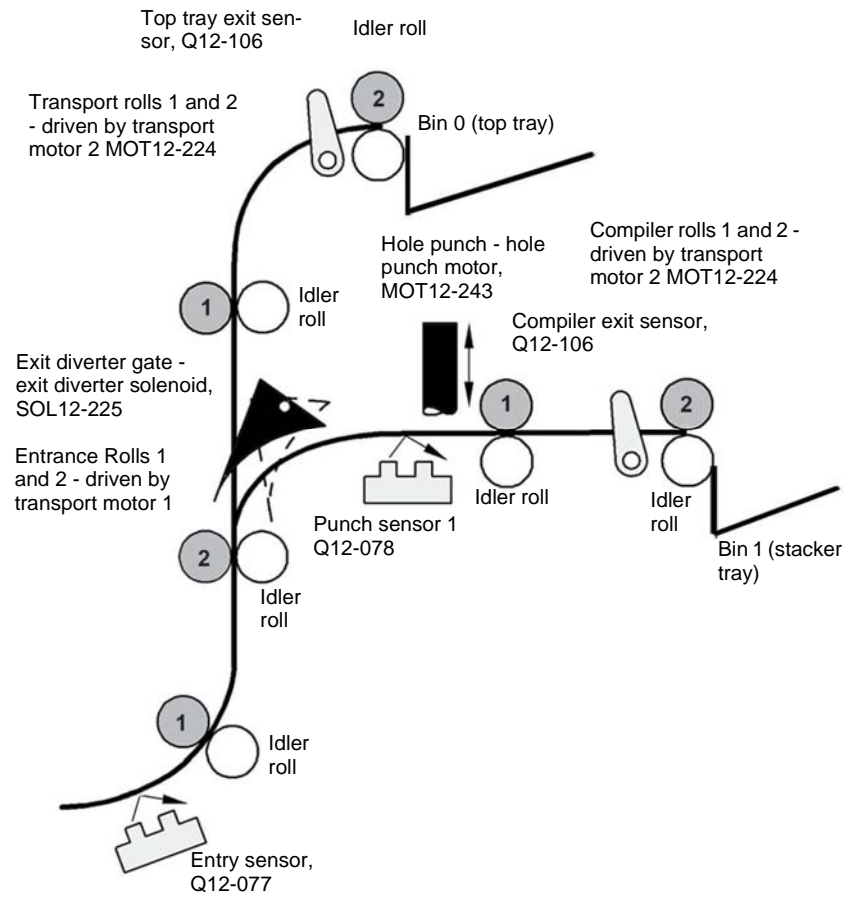
X-5-0034-A

Figure 3 2K LCSS paper path

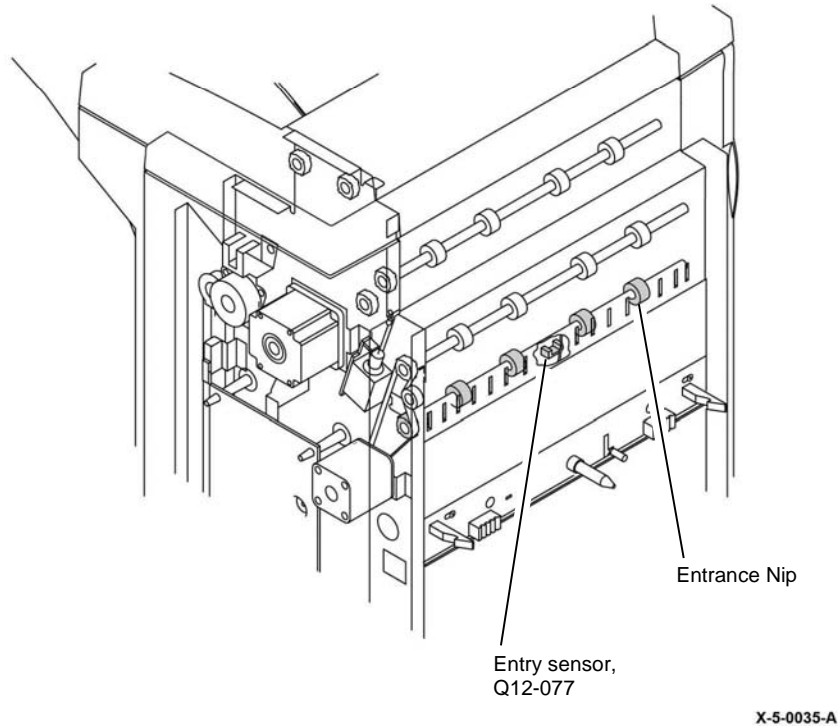
Refer to Figure 4. The entry sensor, Q12-077 is located in the 2K LCSS entrance paper path. In addition to supplying the 2K LCSS PWB with jam detection information, the sensor signal is used to time the operation of components in the 2K LCSS.

Figure 4 Entry sensor

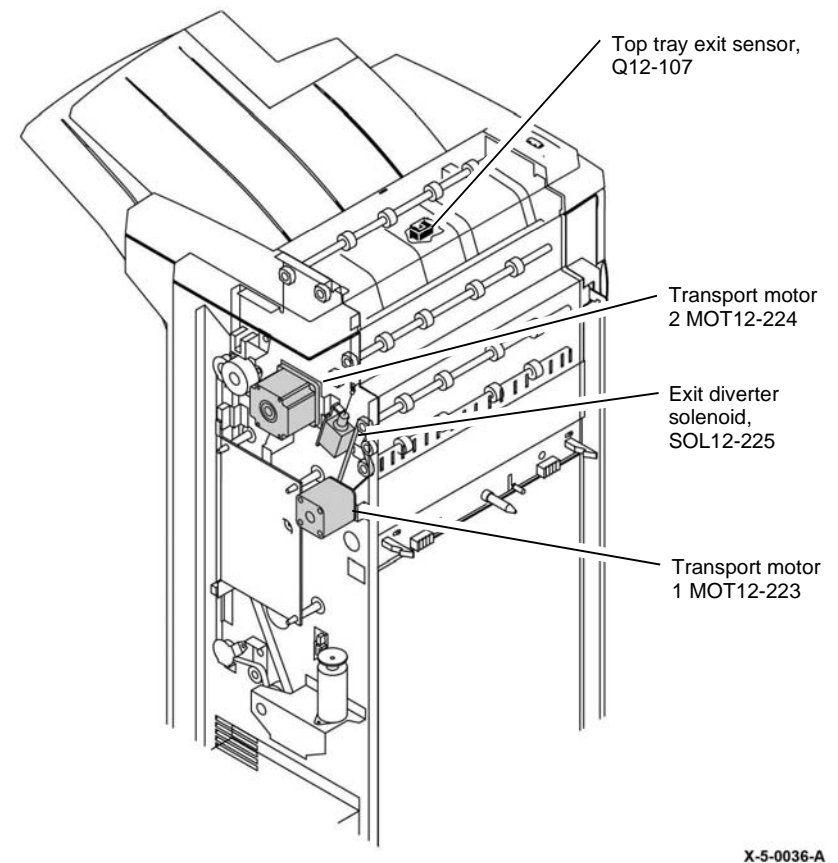
Sheets continue up the entrance paper path, by way of two sets of nip rolls, to the exit diverter gate. The gate is opened by the exit diverter gate solenoid, SOL12-225.

If the gate is open, sheets are diverted to bin 0. If the gate is closed, sheets continue to the hole punch unit, compiler, and bin 1 (stacker tray).

Figure 5 Transport components

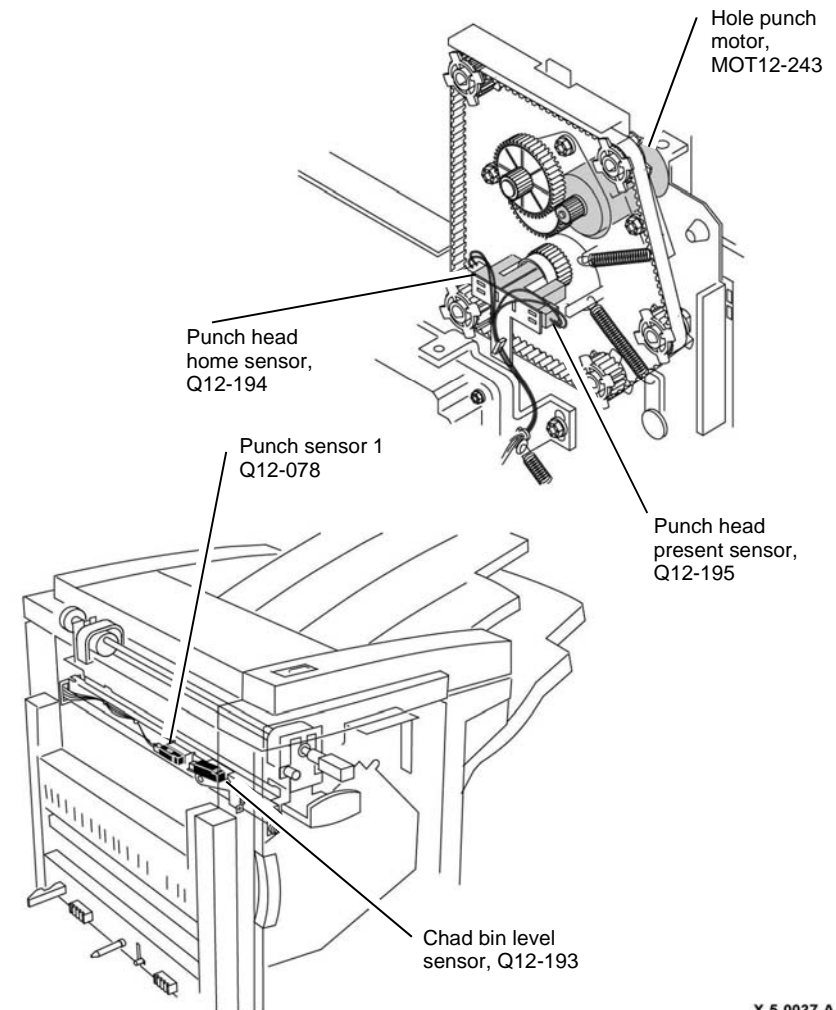
X-5-0037-A

Refer to [Figure 6](#). As sheets are received in the 2K LCSS entrance paper path, the exit diverter gate remains closed and the sheets are directed to the hole punch unit. If hole punching is not requested, sheets pass straight through the hole punch unit to the compiler.

If hole punching has been requested, punch sensor 1, Q12-078 senses the trail edge of the sheet, the sheet is halted in the correct position by the 2K LCSS PWB controlling transport motor 2, MOT12-223. The hole punch motor, MOT12-243 is then energized to punch the sheet, the hole punch motor continues to be driven until the punch head home sensor, Q12-194 sends a signal to the 2K LCSS PWB, so that the hole punch motor is stopped at the home position.

Figure 6 Hole punch unit

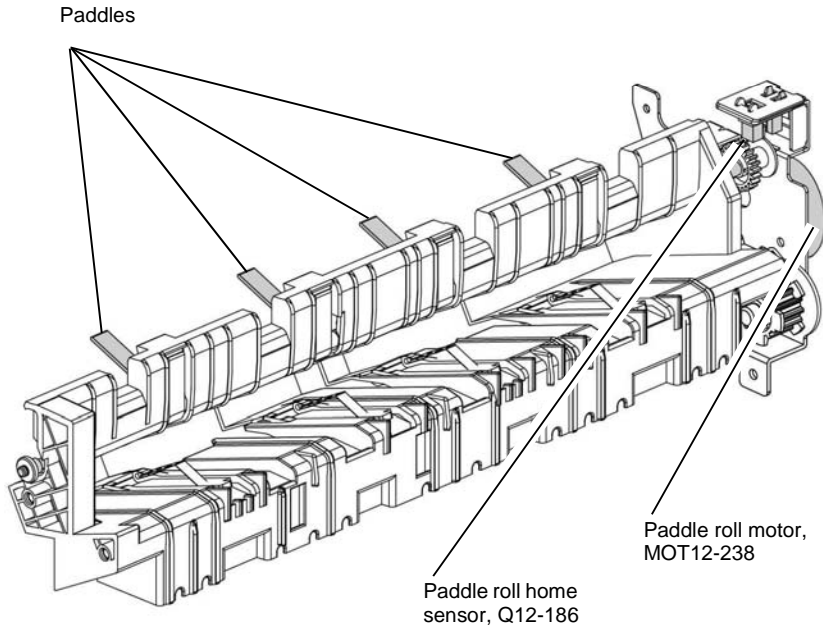
X-5-0038-A

The home position is arranged to park the paddle fingers inside of the output cover profile, so that set ejection is not impeded by the rubber paddle fingers.

Figure 7 Paddle shaft assembly

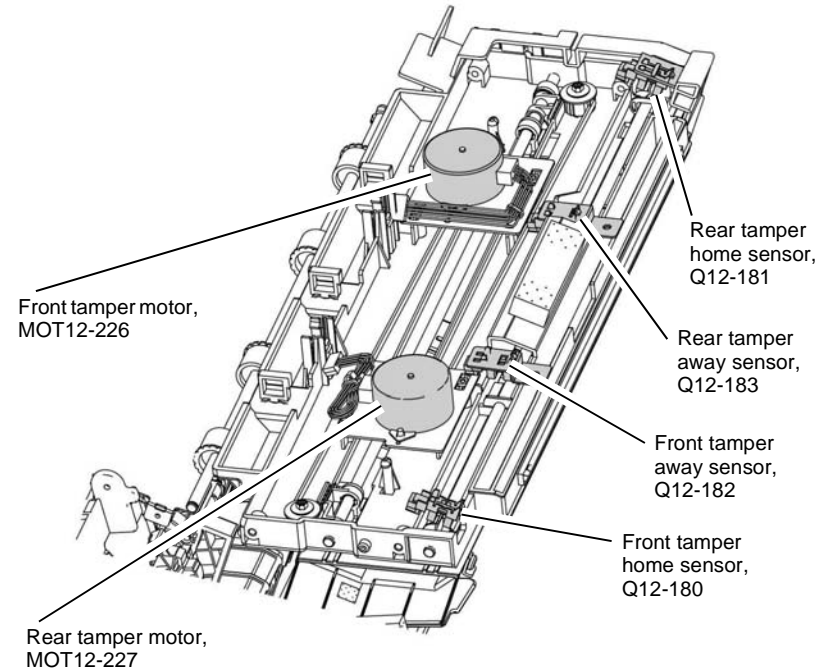
X-5-0039-A

Refer to [Figure 8](#). The purpose of the tamping function is to align the sheets in the compiler to eliminate skew and offset. Tamping registers all sheets in the correct position, as a set, for correct stapling.

Figure 8 Tamping components

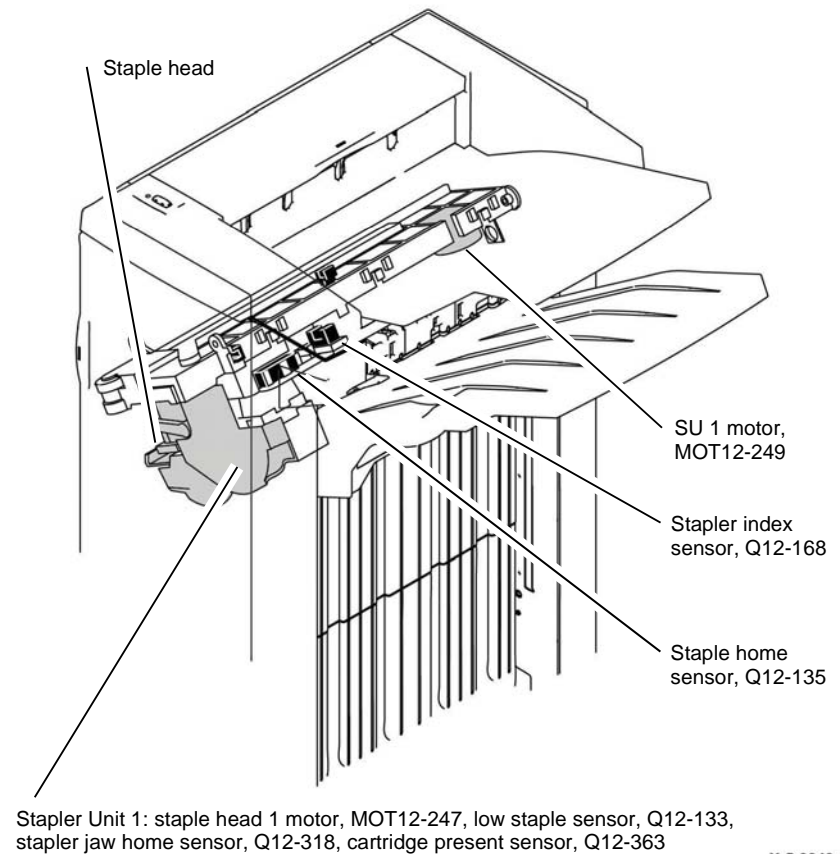
Refer to [Figure 9](#) and [Figure 10](#). The purpose of the stapler is to staple the compiled sets in the compiler tray. Up to 50 sheets of (80gsm/20lb) paper can be stapled. Single or double stapling is available on the left edge of the set, corner stapling is also available.

Figure 9 Stapler unit 1 components

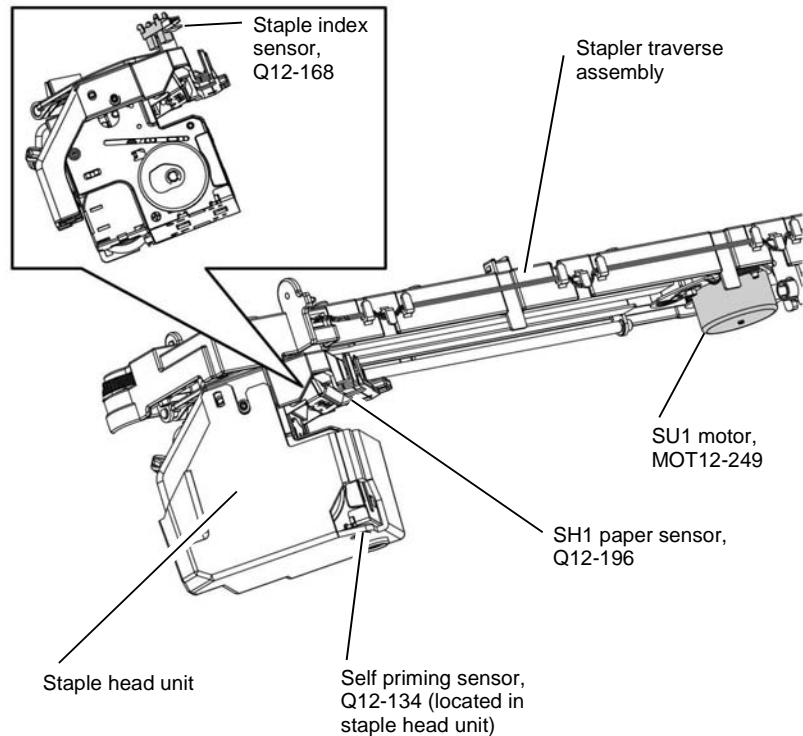
X-5-0041-A

The stapler traverse assembly contains a linear slide and 'J' shaped guide with a sliding stapler mounting which is driven by the SU 1 motor, MOT12-249. The stapler traverse assembly positions the stapler at the various positions necessary for the stapling operation

Figure 10 Staple head and traverse assembly

The staple head unit 1 assembly is mounted on the stapler traverse assembly, which moves the stapler to the various stapling positions within the compiler. Drive is provided by the SU 1 motor, MOT12-249 which drives the stapler mounting along a track via a toothed rubber belt, to position the stapler. The stapler home sensor, Q12-135 senses when the stapler is at the home position.

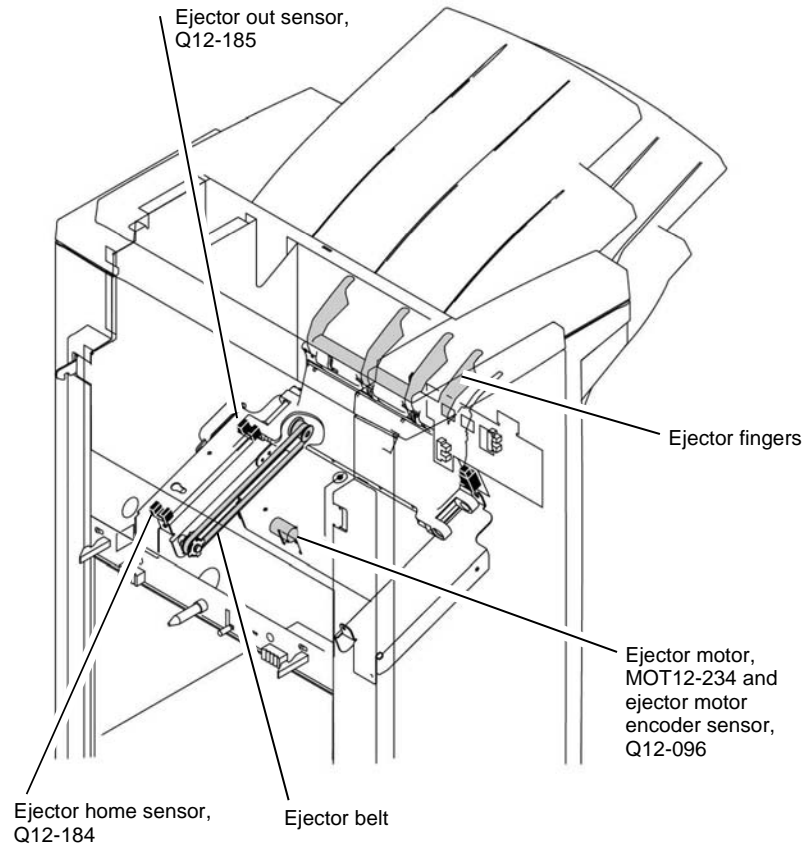
X-5-0042-A

The ejector motor, MOT12-234 drives a pulley which in turn drives the ejector belt to move the ejector. The rotates counter clockwise to eject sets and clockwise to return to the home position.

Figure 11 Eject assembly components

Refer to [Figure 11](#). When any of these conditions are met, the ejector motor, MOT12-234 is run to eject the set. The motor rotates clockwise, driving the ejector belt. The ejector belt moves the ejector forward to eject the set into bin 1 (stacker tray). When the ejector actuates the ejector out sensor, Q12-185, the ejector motor rotates counter clockwise. When the ejector actuates the ejector home sensor, Q12-184, the motor is stopped.

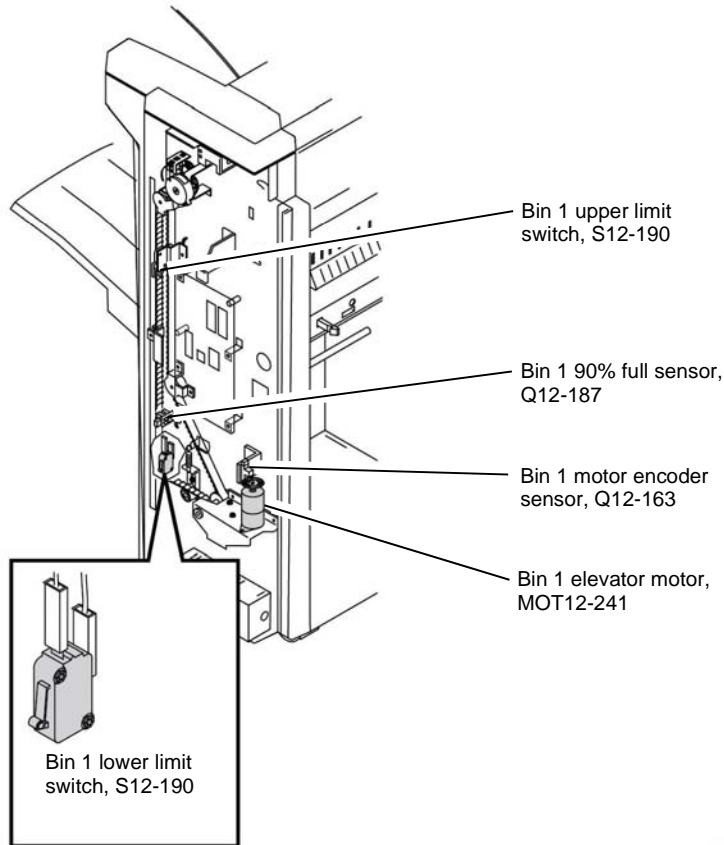
Refer to [Figure 12](#) and [Figure 13](#). Bin 1 of the 2K LCSS provides a platform to stack up to 2000 sheets. The bin 1 tray surface or the top of the stack in bin 1, assists in the compiling mode by providing an extended surface to support longer documents, e.g. SEF A4 (8.5 x 11 inches) and A3 (11 x 17 inches).

Figure 12 Bin 1 components
