708P91368
September 2017

Xerox® AltaLink® B8090 Family Multifunction Printer Service Manual

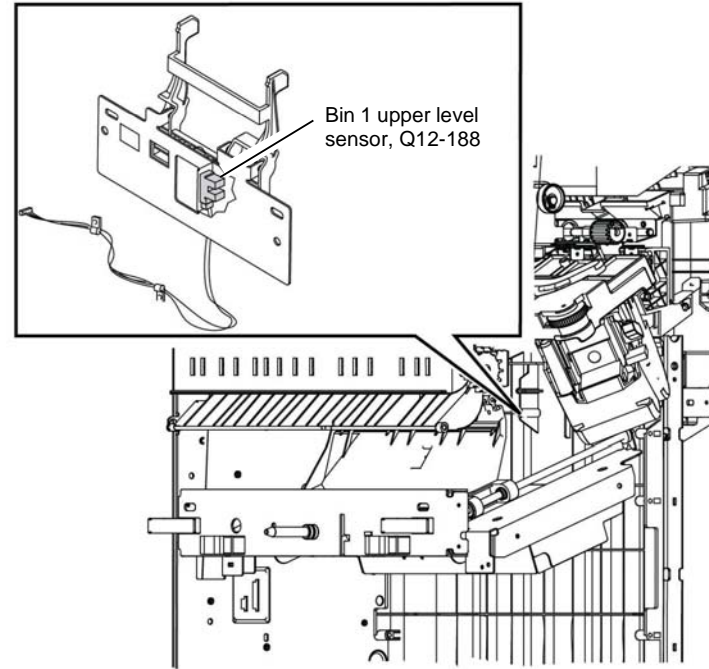
X-5-0043-A

The bin 1 upper level sensor, Q12-188 senses the top of the stack. This signal is used by the 2K LCSS PWB to determine when to lower bin 1 in steps to maintain the correct stack height, with regard to the output from the compiler. The bin 1 90% full sensor, Q12-187 is used to signal when bin 1 is 90% full. The control logic will allow 10% more set feeds prior to declaring a bin 1 full status to the 2K LCSS PWB.

Figure 13 Bin 1 upper level sensor

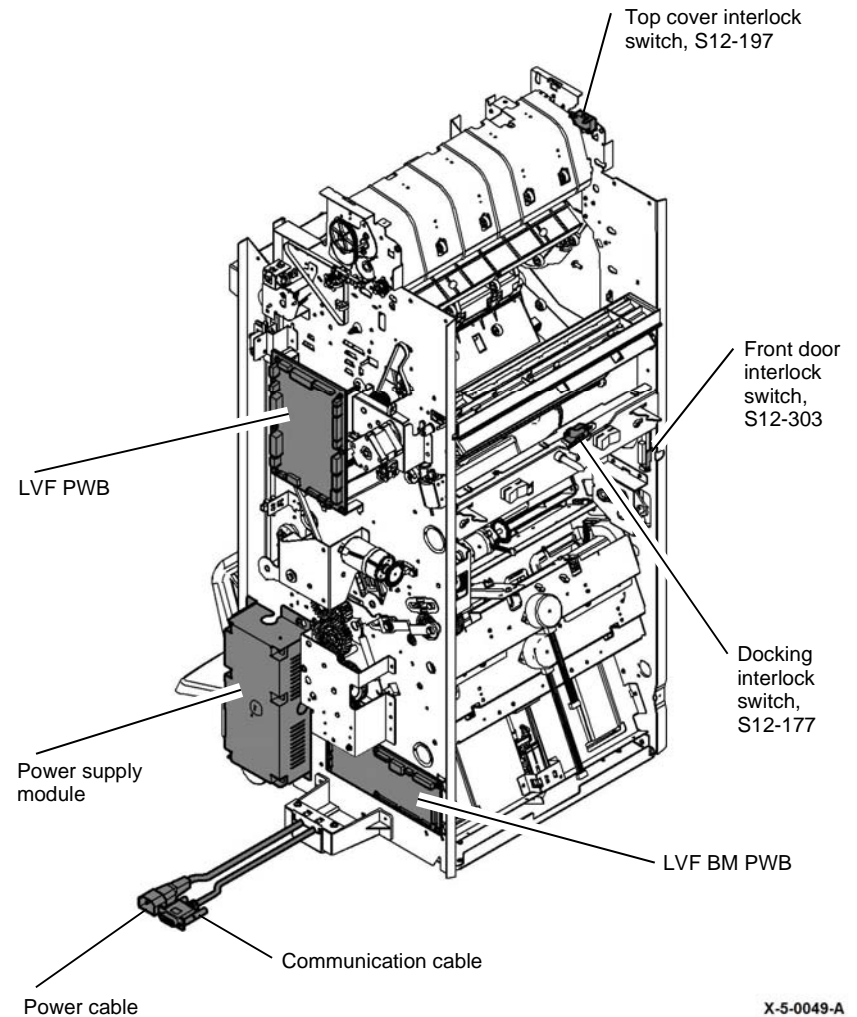
X-5-0049-A

Refer to [Figure 1](#). The functions of the LVF BM are controlled by the IOT via a communications cable connected between the IOT PWB and the LVF PWB. Communication signals travel in both directions to and from the processors in both devices.

Figure 1 Power, control and interlock components

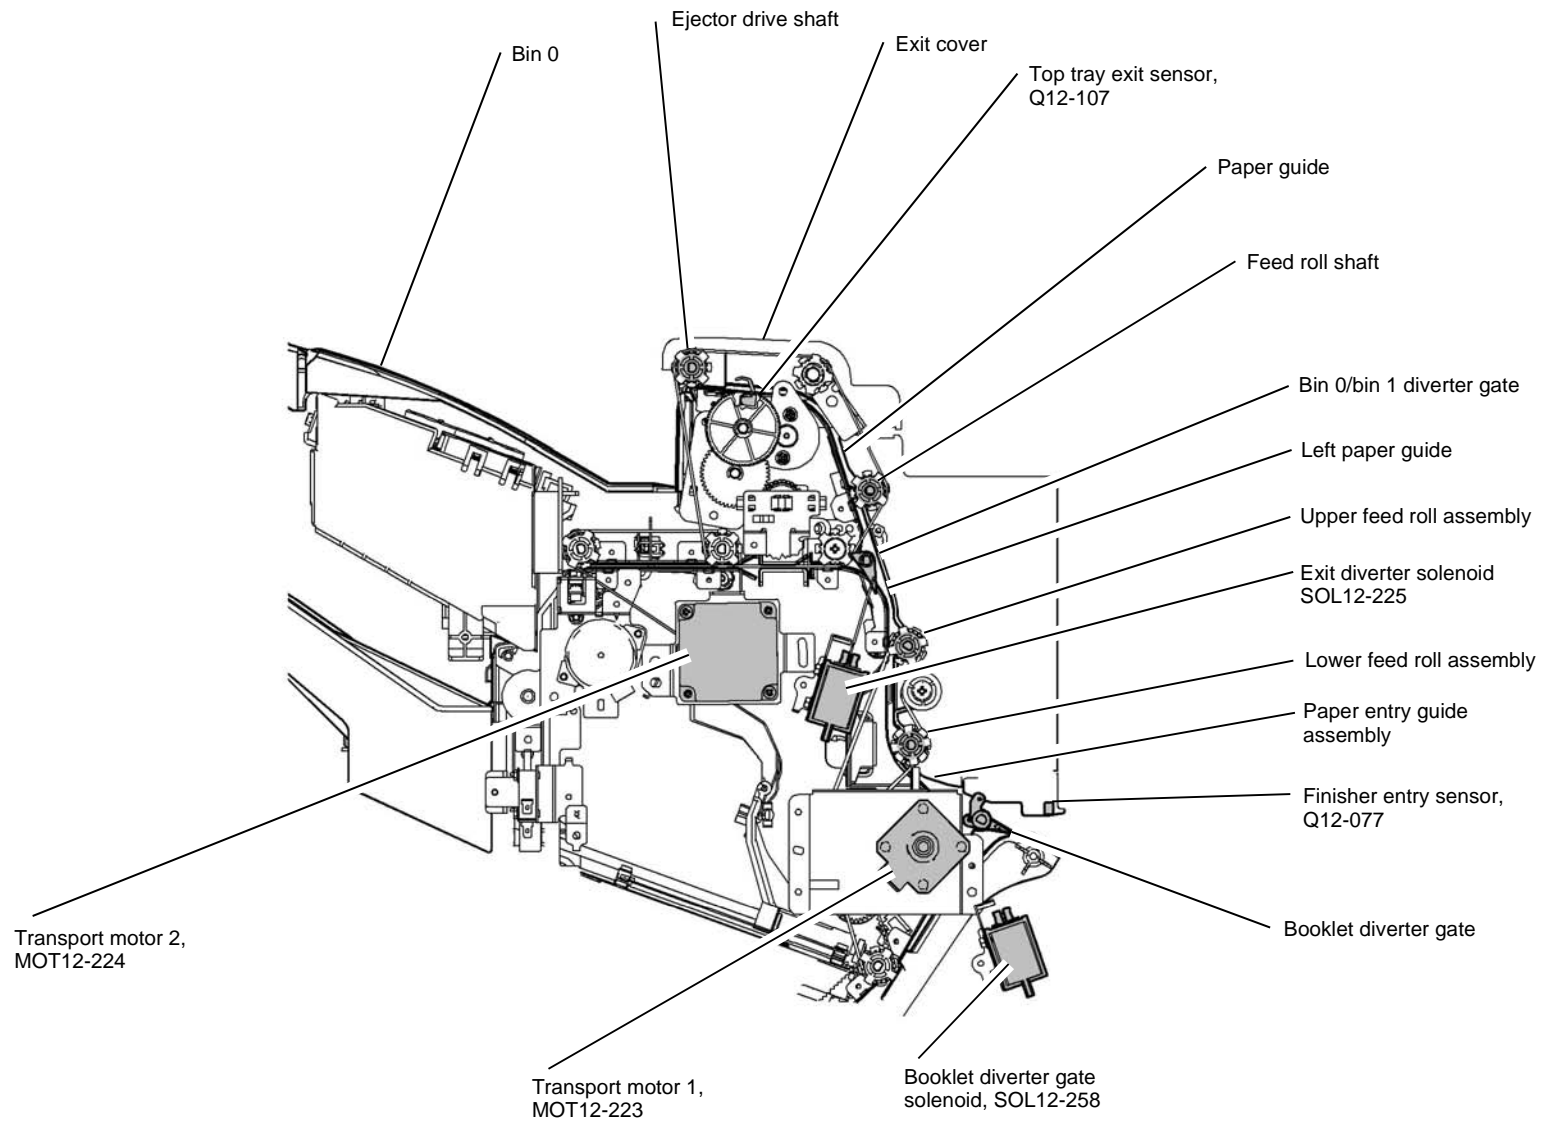
X-5-0050-A

1. Paper enters the LVF BM, then actuates the finisher entry sensor, Q12-077.
2. The de-energized booklet diverter gate solenoid, SOL12-258 holds the booklet diverter gate in position to send the paper upwards through the paper entry guide assembly and left paper guide to the bin0/bin 1 diverter gate. The paper is driven by the lower feed roll assembly and the upper feed roll assembly, both are driven by transport motor 1, MOT12-223.
3. The energized bin 0/bin 1 diverter solenoid holds the bin 0/bin 1 diverter gate in position to send the paper upwards between the paper guide and the exit cover, driven by the feed roll shaft.
4. The paper actuates the top tray exit sensor, Q12-107 and gets fed into bin 0 by the ejector drive shaft. The feed roll shaft and the ejector drive shaft are driven by transport motor 2, MOT12-224.

Figure 2 Paper path to bin 0 components

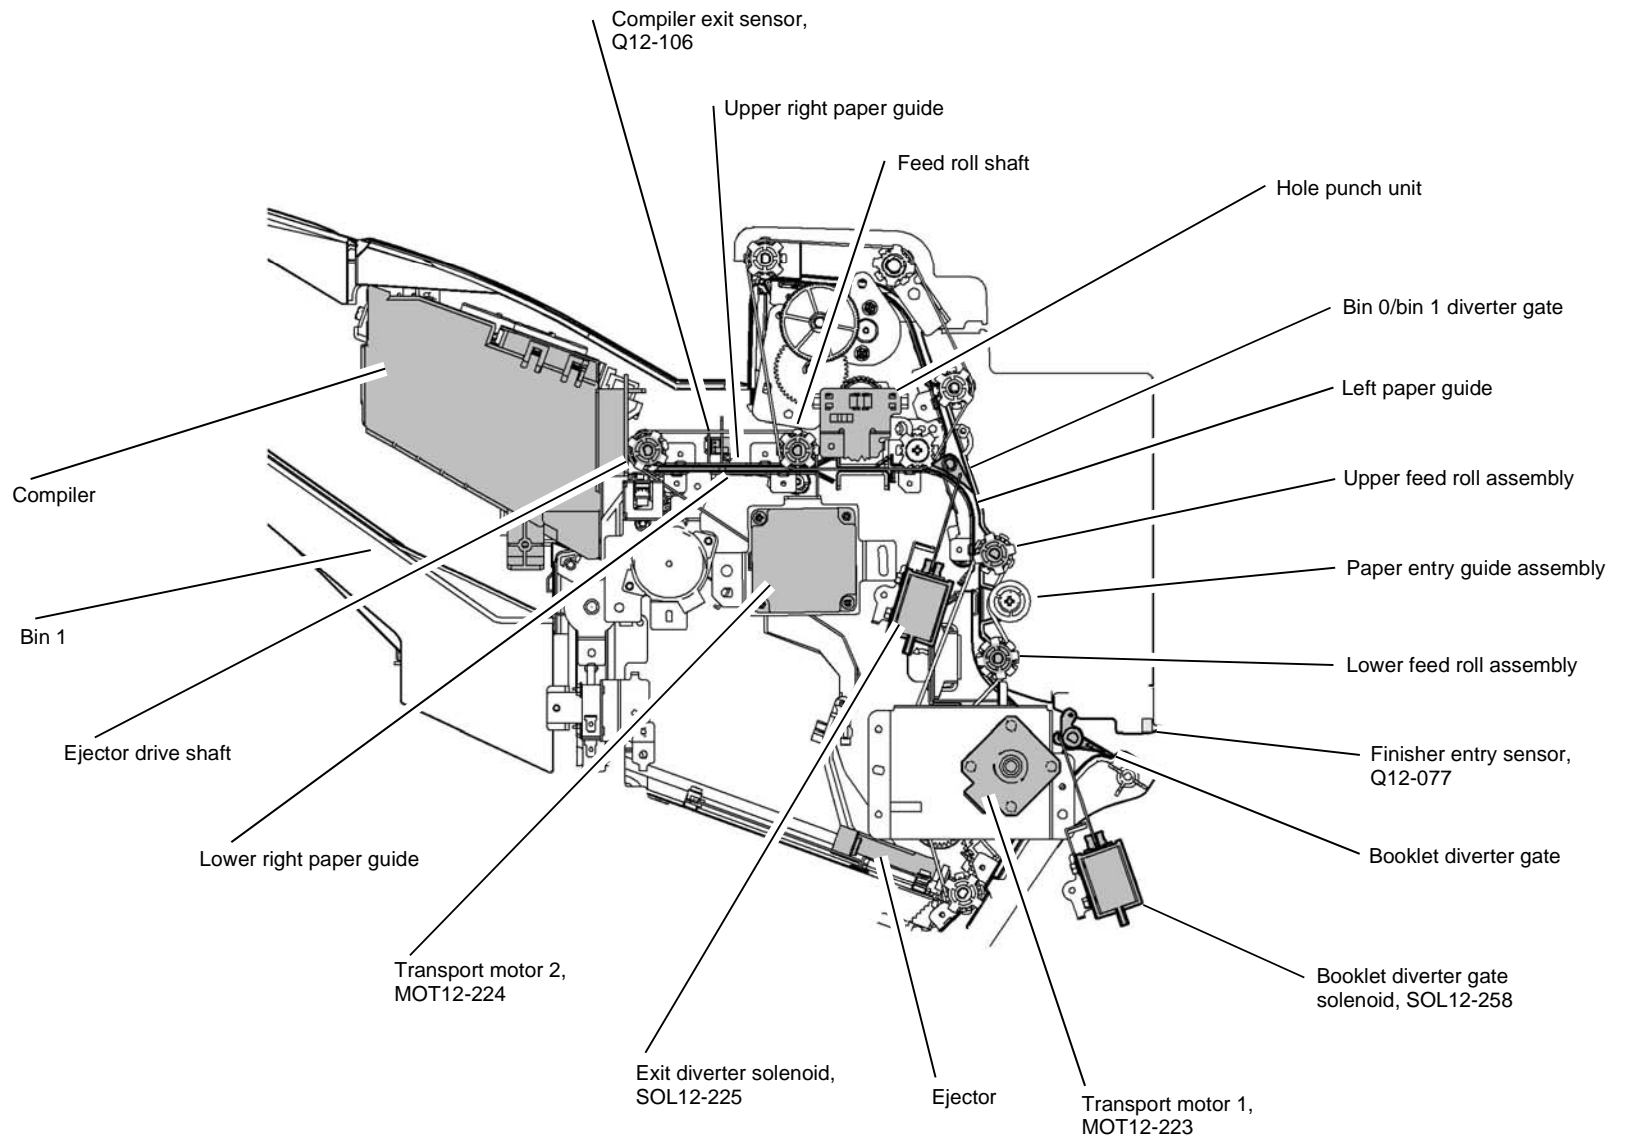
X-5-0051-A

4. The paper is then driven by the feed roll shaft through the gap between the upper and lower right paper guides.
5. The paper actuates the 2nd to top tray exit sensor, Q12-107 and gets fed into the compiler by the ejector drive shaft. The feed roll shaft and the ejector drive shaft are driven by transport motor 2, MOT12-224.

6. The compiler receives the paper. If set compiling is required the pages are accumulated and tamped into a set. If set stapling is required, the stapler is energized to staple the set in the specified places. The completed set is then ejected into bin 1 by the ejector.

Figure 3 Paper path to bin 1 components

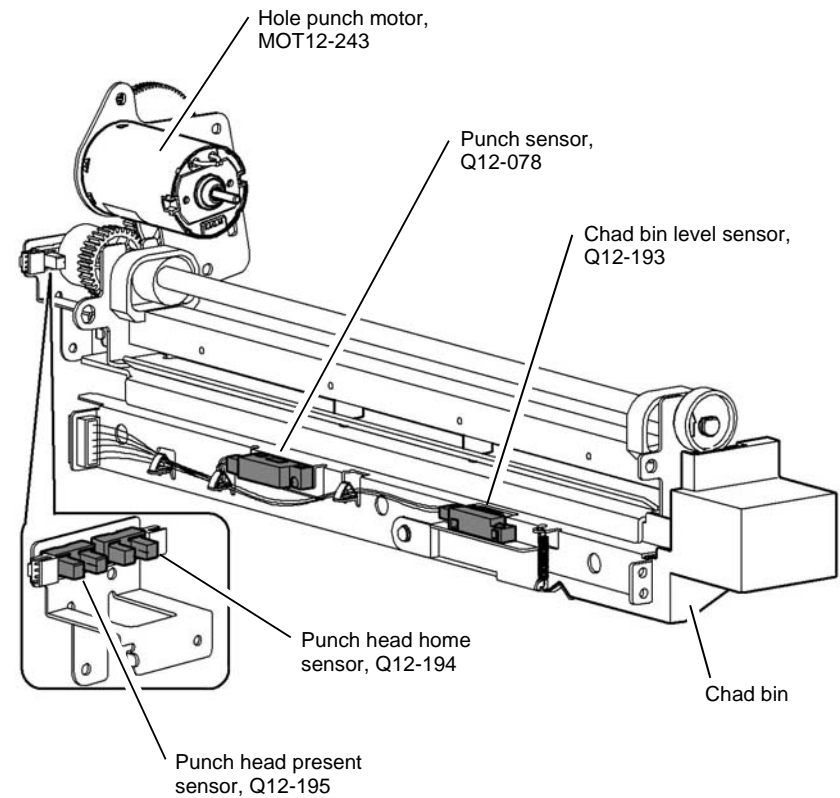
X-5-0053-A

Pages that are required to be punched are sent along the paper path towards bin 1. The punch sensor, Q12-078 signals the LVF PWB controller when the trail edge of the sheet is seen. The LVF PWB then drives the hole punch motor for one cycle to punch the paper one sheet at a time. The punch head home sensor, Q12-194 signals the LVF PWB controller when the rotation of the punch cam shaft has reached the home position, the LVF PWB controller then turns off the hole punch motor.

The chad from the hole punching operation falls down into the chad bin below the hole punch. A cam on the front of the hole punch unit rotates to tamp the chad in the chad bin to settle the contents and increase the capacity. The chad bin level sensor, Q12-193 signals the LVF PWB controller when the chad bin needs to be emptied, this results in a message being displayed on the user interface, requesting that the chad bin be emptied.

Figure 5 Hole punch unit components

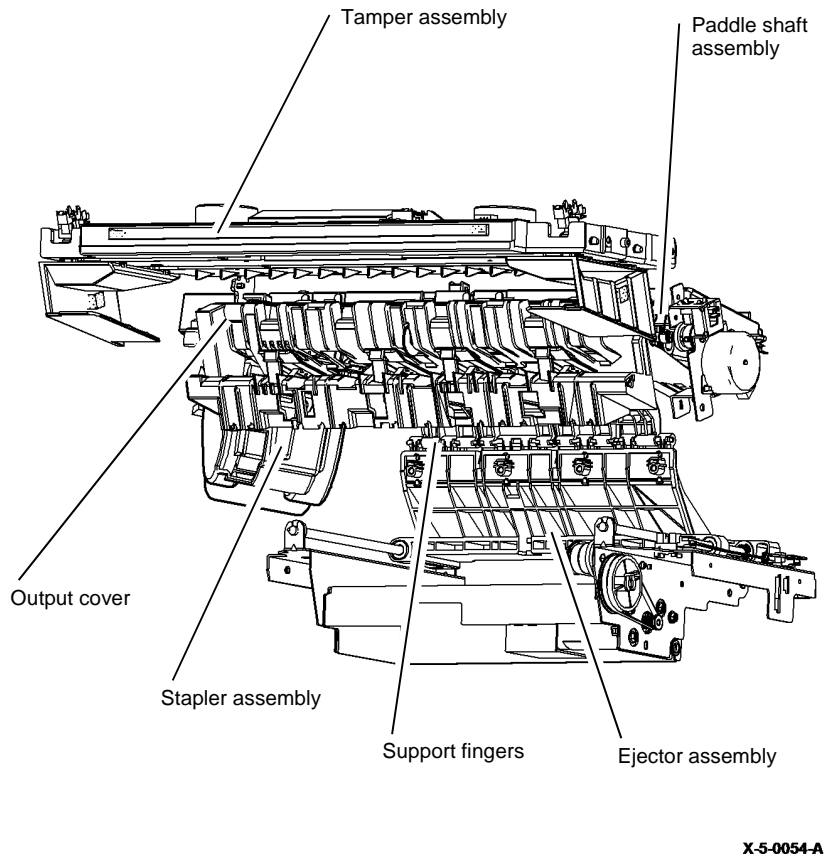
Refer to Figure 6. The compiler collects pages of output and compiles them into sets that can be stapled in various ways, then offsets the sets into bin 1. The left section of the compiler is formed by the shape of the output cover, the right side of the compiler is formed by the two tamper arms. The support fingers of the ejector assembly support the pages from below.

Figure 6 Compiler components

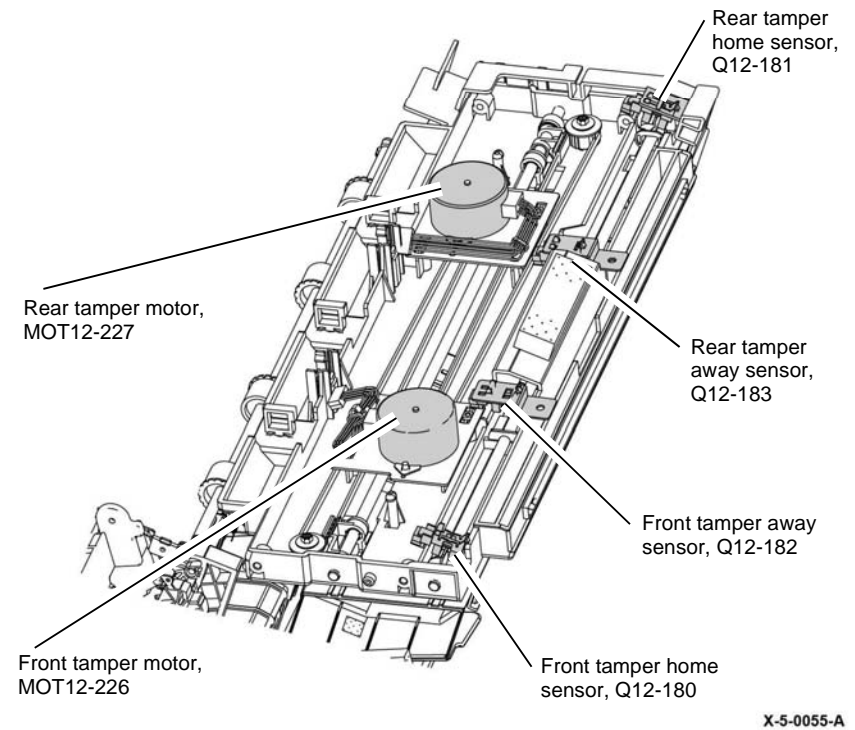
Refer to Figure 7. The purpose of the tamping function is to align the sheets in the compiler carriage to eliminate skew and offset. Tamping registers all sheets in the correct position, as a set, for correct stapling.

When the first sheet of a set is about to enter the compiler, the tamper arms are moved from the home position to the ready position. The ready position is paper size dependent and the information is obtained from the IOT. When each sheet of the set is fully within the compiling area, the tamper arms are moved to the tamp position and then back to the ready position to wait for the next sheet. The tamper arms are moved back to the ready position at a slower speed so that an overtamp buckle is avoided which could move sheets out of the registered position.

Figure 7 Tamper assembly components

The front tamper is moved along a track by a toothed belt driven by the front tamper motor, MOT12-226. The home position of the front tamper is sensed by the front tamper home sensor, Q12-180. The task of the front tamper is to align the front of the set with the inner front wall of the output cover, this alignment position is the same for all paper sizes.

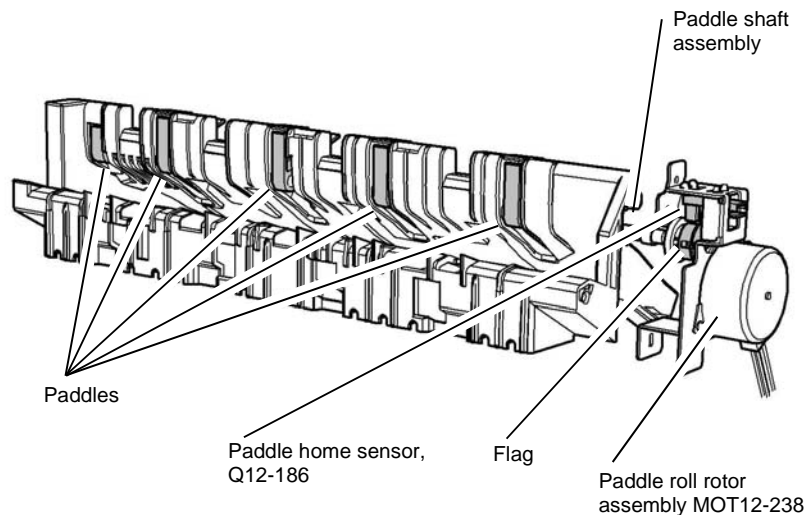
X-5-0056-A

Refer to [Figure 8](#). The paddle shaft assembly is positioned in the top section of the output cover and is used to drive the sheets of paper fully left against the edge of the output cover.

As each sheet arrives in the compiler, the paddle shaft assembly is rotated one revolution from the home position to drive the sheet fully to the left of the compiler. The home position is sensed when the flag on the paddle shaft enters the paddle home sensor, Q12-186. The home position is arranged to park the paddle fingers inside of the output cover profile, so that paper movement is not impeded by the rubber paddle fingers.

Figure 8 Paddle wheel assembly components

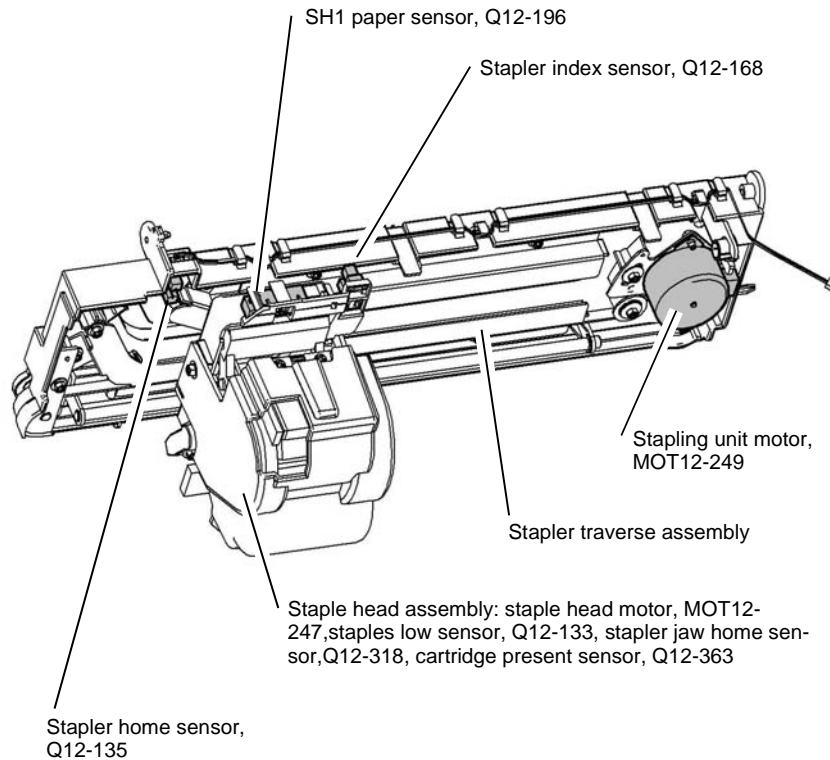
X-5-0057-A

The SH1 low staples sensor, Q12-133 (located within the staple head) is used to detect the presence of staples in the stapler. The sensor signals the control logic when the cartridge is low on staples.

The cartridge present sensor, Q12-363 (located within the staple head) is used to detect the presence of a staple cartridge in the stapler. The sensor signals the control logic when the cartridge is missing from the staple head.

Figure 9 Stapler assembly components

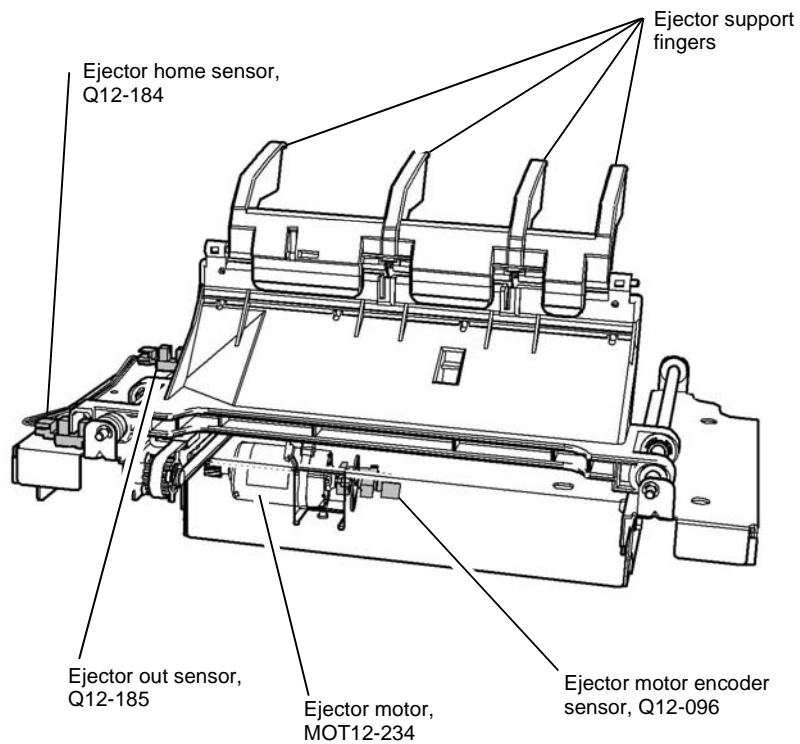
X-5-0058-A

The ejector slides between the home and out positions supported on two parallel shafts and is driven by the ejector motor, MOT12-234. The ejector home sensor, Q12-184 monitors the home position of the ejector and the ejector out sensor, Q12-185, monitors the out position of the ejector.

The ejector support fingers are spring mounted onto the ejector. When the set is complete and the stapler head is in the home (corner) position, the ejector is driven to the home position, during travel to the home position the support fingers are deflected downwards under the set and spring back upwards at the home position where they are clear of the edge of the set. The ejector is then moved to the out position thereby ejecting the set to bin 1. If the set just produced was the last or only set of the job, the ejector now returns to the home position. If there are further sets to be produced in the job, the ejector remains in the out position while the next set is built in the compiler.

Figure 10 Ejector assembly components

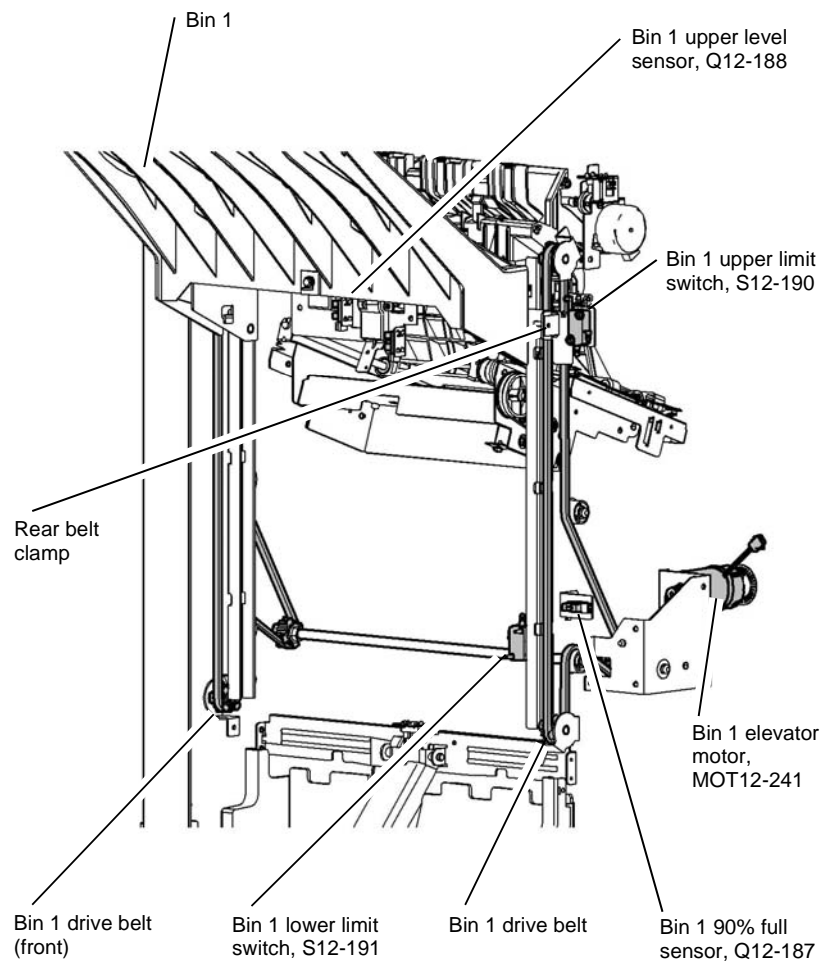
X-5-0059-A

The bin 1 90% full sensor, Q12-187 is positioned so that a flag mounted on the rear belt clamp enters the sensor when bin 1 is approximately 90% full. The signal from this sensor results in a message being displayed on the user interface requesting the operator to unload bin 1.

The bin 1 upper limit switch, S12-190 and bin 1 lower limit switch, S12-191 are positioned to monitor any over travel of bin 1. They will remove the +24V supply to the bin 1 elevator motor, MOT12-241 if over travel occurs due to component failure.

Figure 11 Bin 1 elevator components

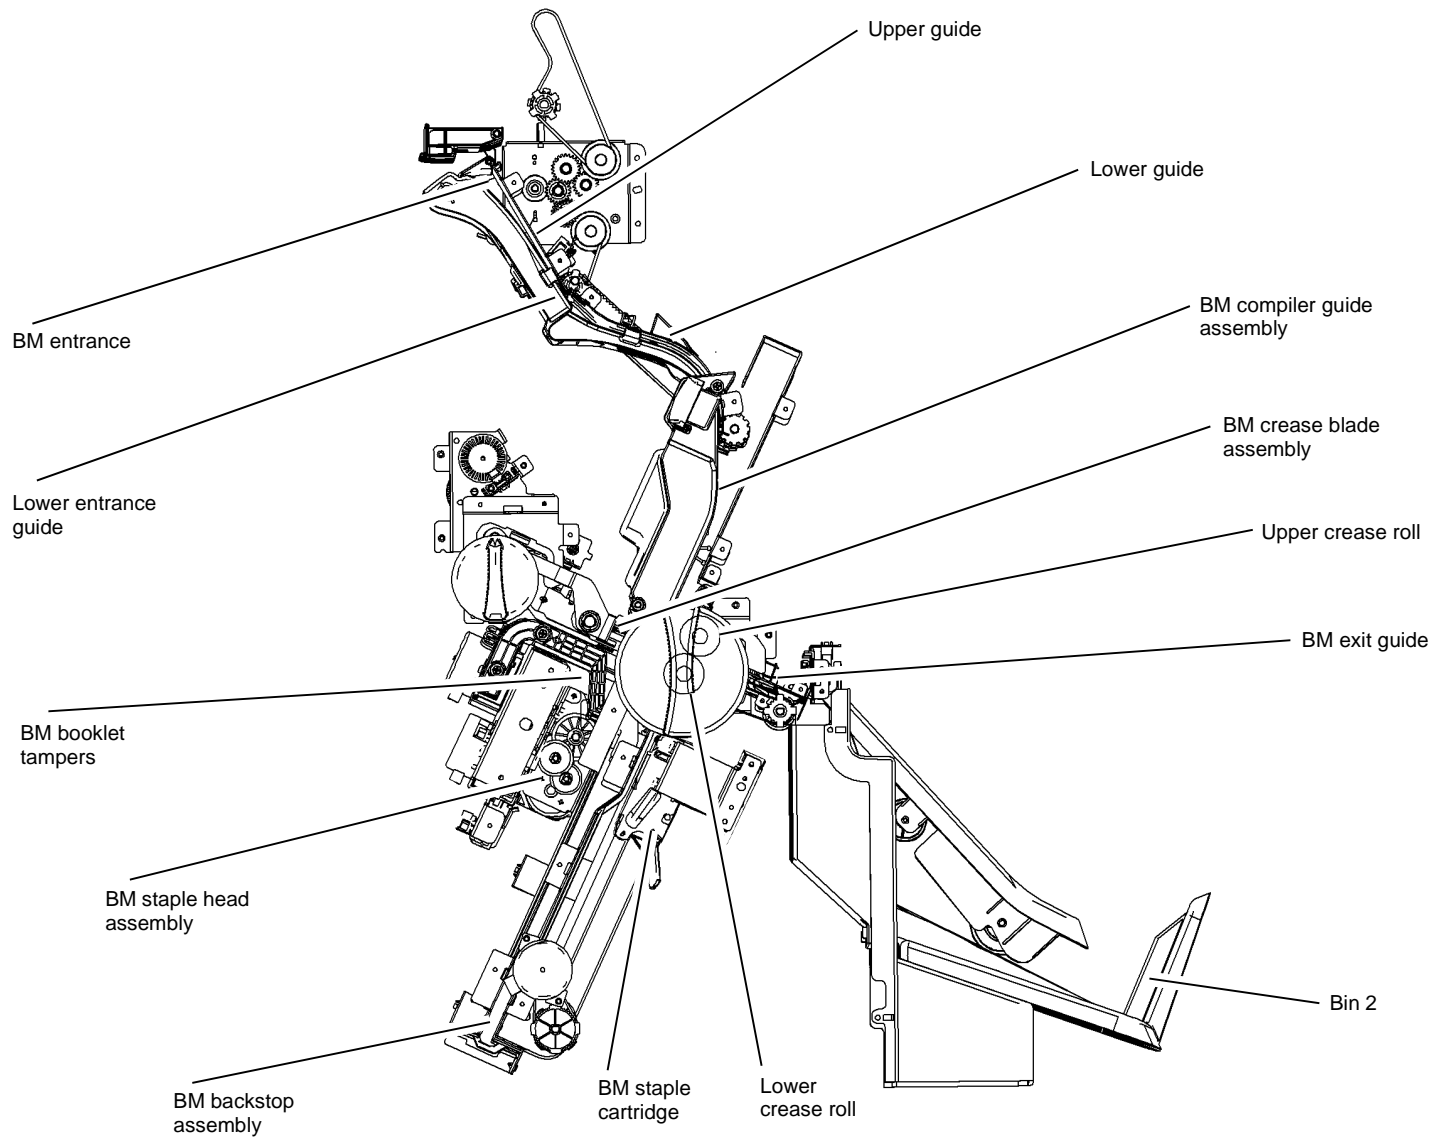
X-5-0060-A

Refer to [Figure 12](#). The booklet maker can collect and process output to form booklets from A3 (11 x 17 inches), A4 (8.5 x 11 inches), 8.5 x 14 inches, 8.5 x 13 inches, and 8.5 x 11 inches short edge feed stock to form A4 (8.5 x 11 inches), A5 (8.5 x 5.5 inches), 8.5 x 7 inches and 8.5 x 6.5 inches booklets respectively (stapled and non stapled). The finished booklets are stacked on bin 2. If stapled booklets are selected they will be dual stapled on the fold line.

Figure 12 Booklet maker components

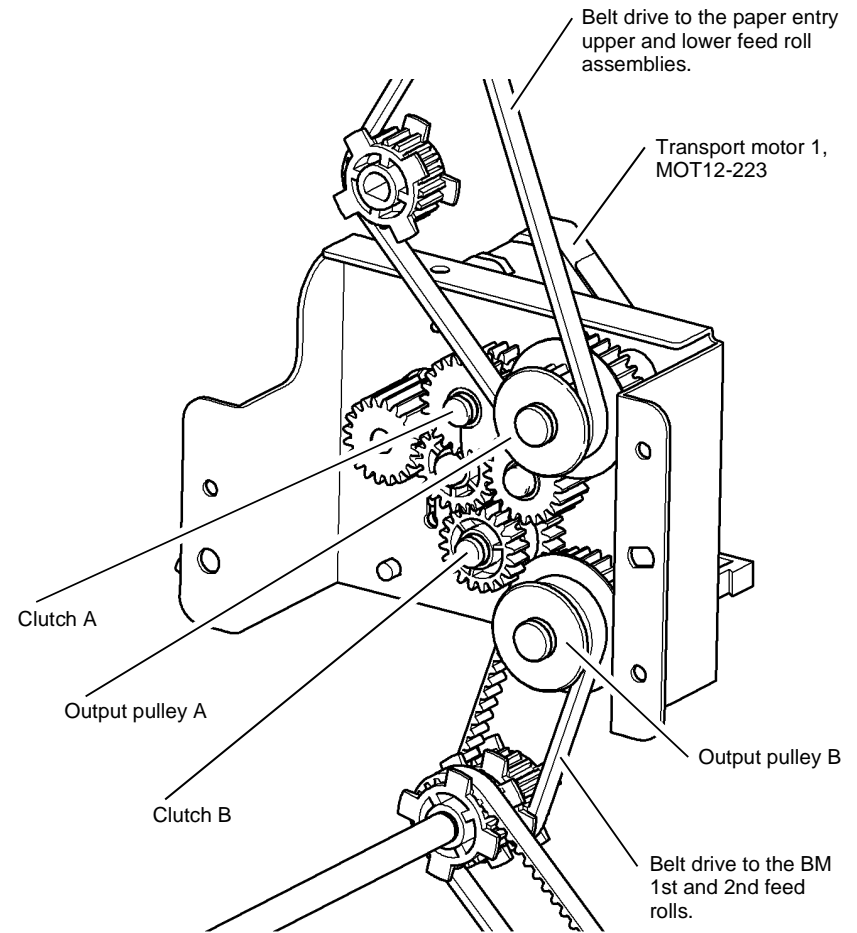
X-5-0061-A

Refer to Figure 13. Transport motor 1, MOT12-223 is used to drive the paper entry upper and lower feed roll assemblies (for bin 0 and bin 1) and also the booklet maker 1st and 2nd feed rolls. This is achieved by taking the drive from the motor through two one way clutches. Clutch A is arranged to engage in a counter clockwise direction, clutch B is arranged to engage in a clockwise direction. In this way when the motor is driven clockwise, clutch B will engage, clutch A will disengage and drive is taken to output pulley B to drive the booklet maker 1st and 2nd feed rolls. When the motor is driven in a counter clockwise direction, clutch A will engage, clutch B will disengage and drive is taken to output pulley A to drive the upper and lower feed roll assemblies.

Figure 13 Transport motor 1 components

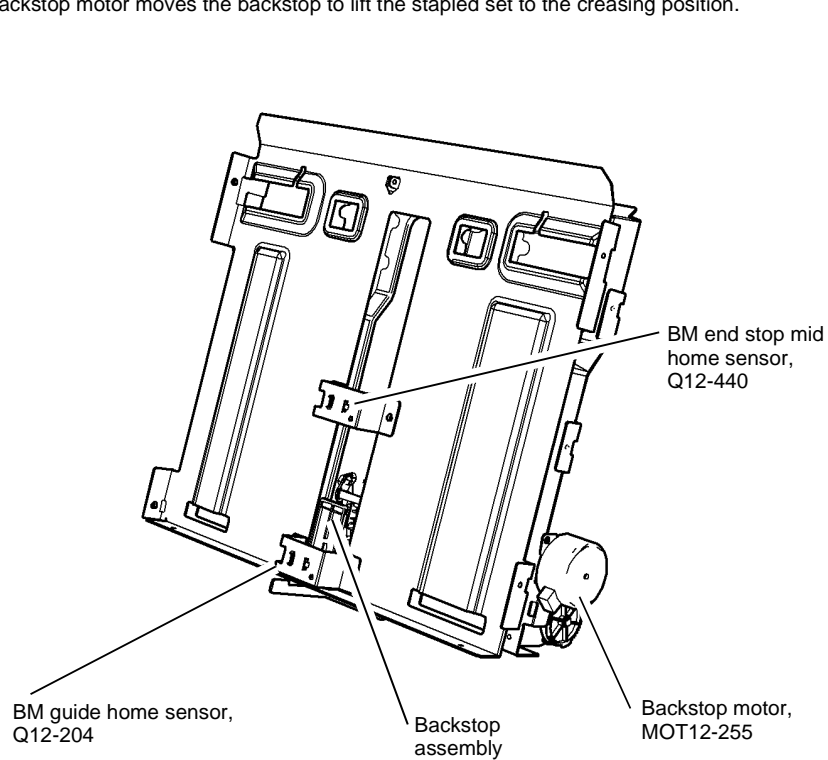
X-5-0062-A

Refer to [Figure 14](#). When the first sheet arrives at the BM entry sensor, Q12-089, the tampers are moved to the ready position. If the sheet is longer than 330mm the backstop motor, MOT12-255 is energized to move the backstop assembly to a ready position based on the paper size value provided by the IOT PWB. The positioning of the backstop for long paper such as A3 (11 x 17 inches), is measured in stepper motor pulses from the backstop home sensor, Q12-204. For shorter paper such as A4 (8.5 x 11 inches), the backstop positioning is measured from the backstop mid home position sensor, Q12-440.

After the last sheet of the set has been received and compiled, the BM backstop motor moves the backstop to lift the set the stapling position, the upward movement causes the set clamp arm to move to the right and hold the set in place during movement. After stapling, the BM backstop motor moves the backstop to lift the stapled set to the creasing position.

Figure 14 BM backstop assembly components

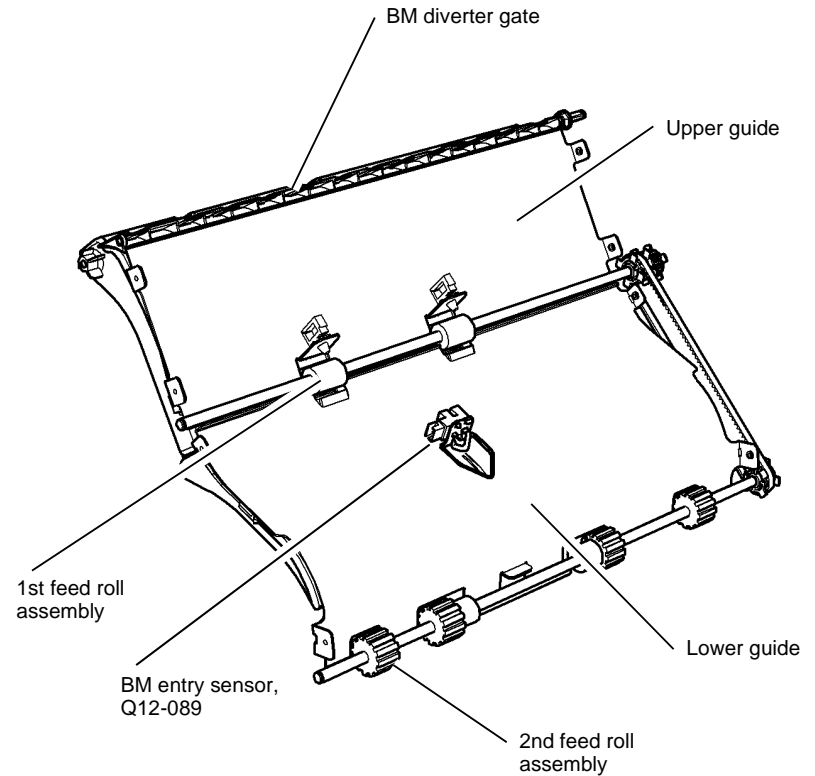
X-5-0063-A

Refer to [Figure 15](#). The booklet maker receives sheets from the BM diverter gate, through the 1st feed roll nip, the BM entry sensor, Q12-089 and the 2nd feed roll nip. As each sheet is fed through the 2nd feed roll nip, it is driven downwards until it rests against the backstop.

The 2nd feed roll has smaller hard rollers and larger soft foam rollers. As the lead edge of each sheet touches the backstop, the trail edge is released by the hard roller nip, but is still held by the soft roller, which pushes the sheet under the roller and against the right side of the booklet compiler. This ensures that the trail edge of every compiled sheet is always located on the right side of the following sheet, thus eliminating both stubbing and sheet order errors.

Figure 15 BM entrance components

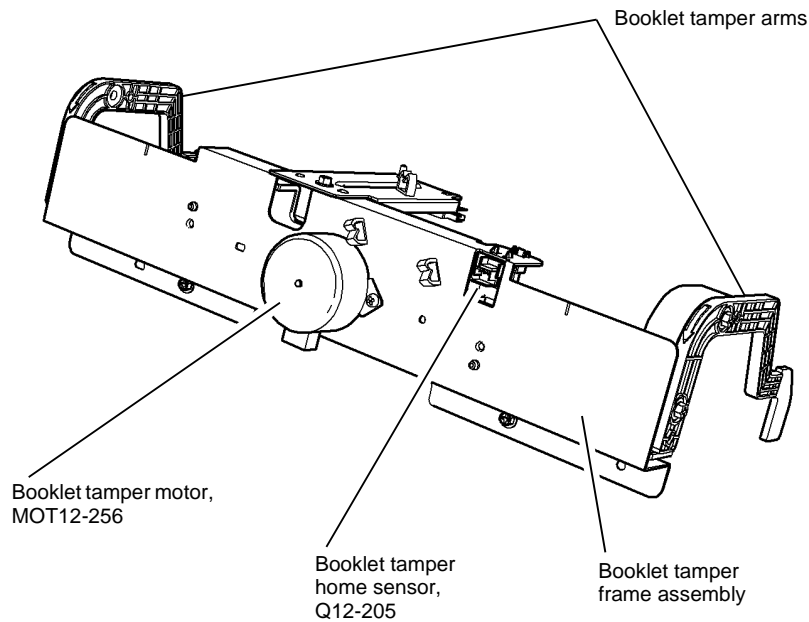
W-5-0064-A

The tamperers are moved from the home position to a ready position stored in NVM, when the lead edge of the first sheet in the set is detected at the BM entry sensor, Q12-089.

700ms after the trail edge of each sheet has left the BM entry sensor, the tamperers are moved from the ready position to the tamping position, then returned to the ready position. For the last sheet of the set, the tamping stroke is repeated once more. After the last sheet in a set is compiled and tamped, the tamperers are moved to the home position.

Figure 16 Booklet tamper components

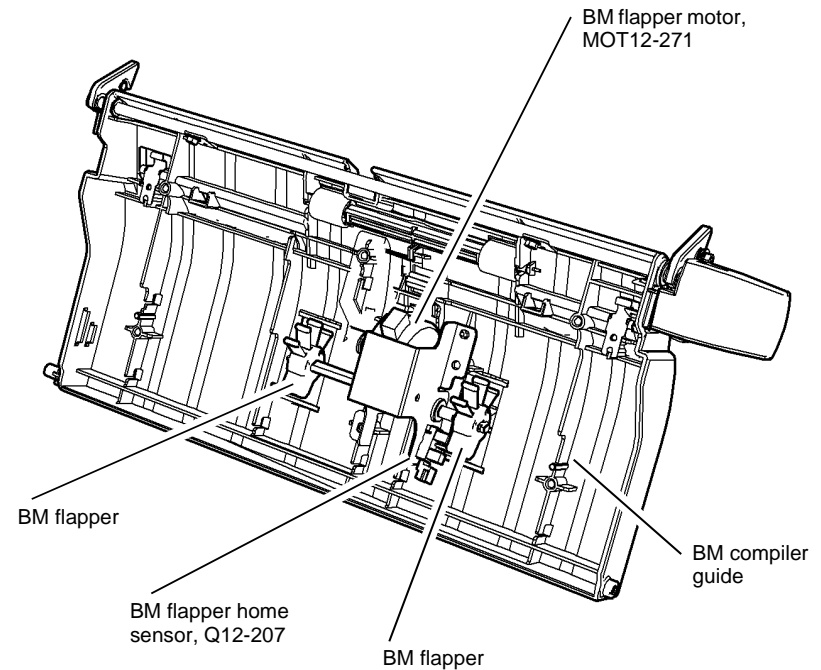
X-5-0065-A

- If the accumulated weight of the set is less than 400gsm the flappers are cycled 3 times.
- If the accumulated weight of the set is between 400 and 800gsm the flappers are cycled 4 times.
- If the accumulated weight of the set is more than 800gsm the flappers are cycled 5 times.

Figure 17 BM flapper assembly components

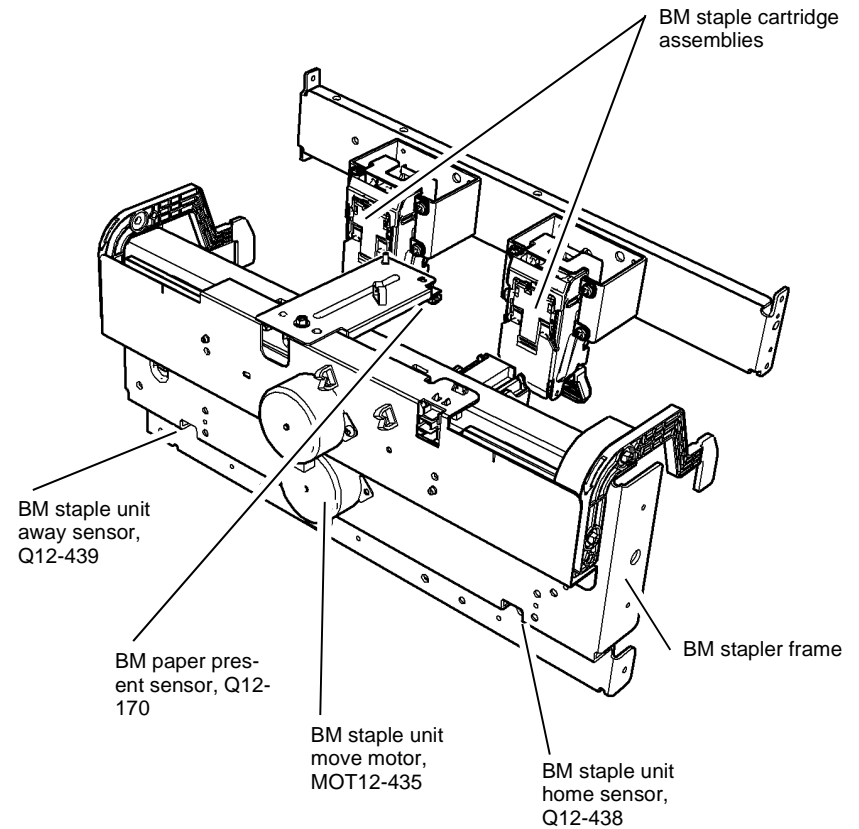
X-5-0066-A

Once the stapler jaw reaches the home position, a dynamic brake is applied to prevent over-run. The stapler motor will be reversed if the stapler jaw home sensor, Q12-411 is not made after the stapling operation, in an attempt to bring the stapler home and avoid a fault.

Once the front staple has been completed the BM staple unit move motor, MOT12-435 is energized to move the BM staple head from the home position to the away position. The BM staple unit home sensor, Q12-438 monitors the home position of the BM staple head. The BM staple unit away sensor, Q12-439 monitors the away position of the BM staple head. Once the rear staple has been completed the BM staple unit move motor, MOT12-435 is energized to move the BM staple head from the away position to the home position in readiness for the next booklet.

Figure 18 BM stapling assembly components

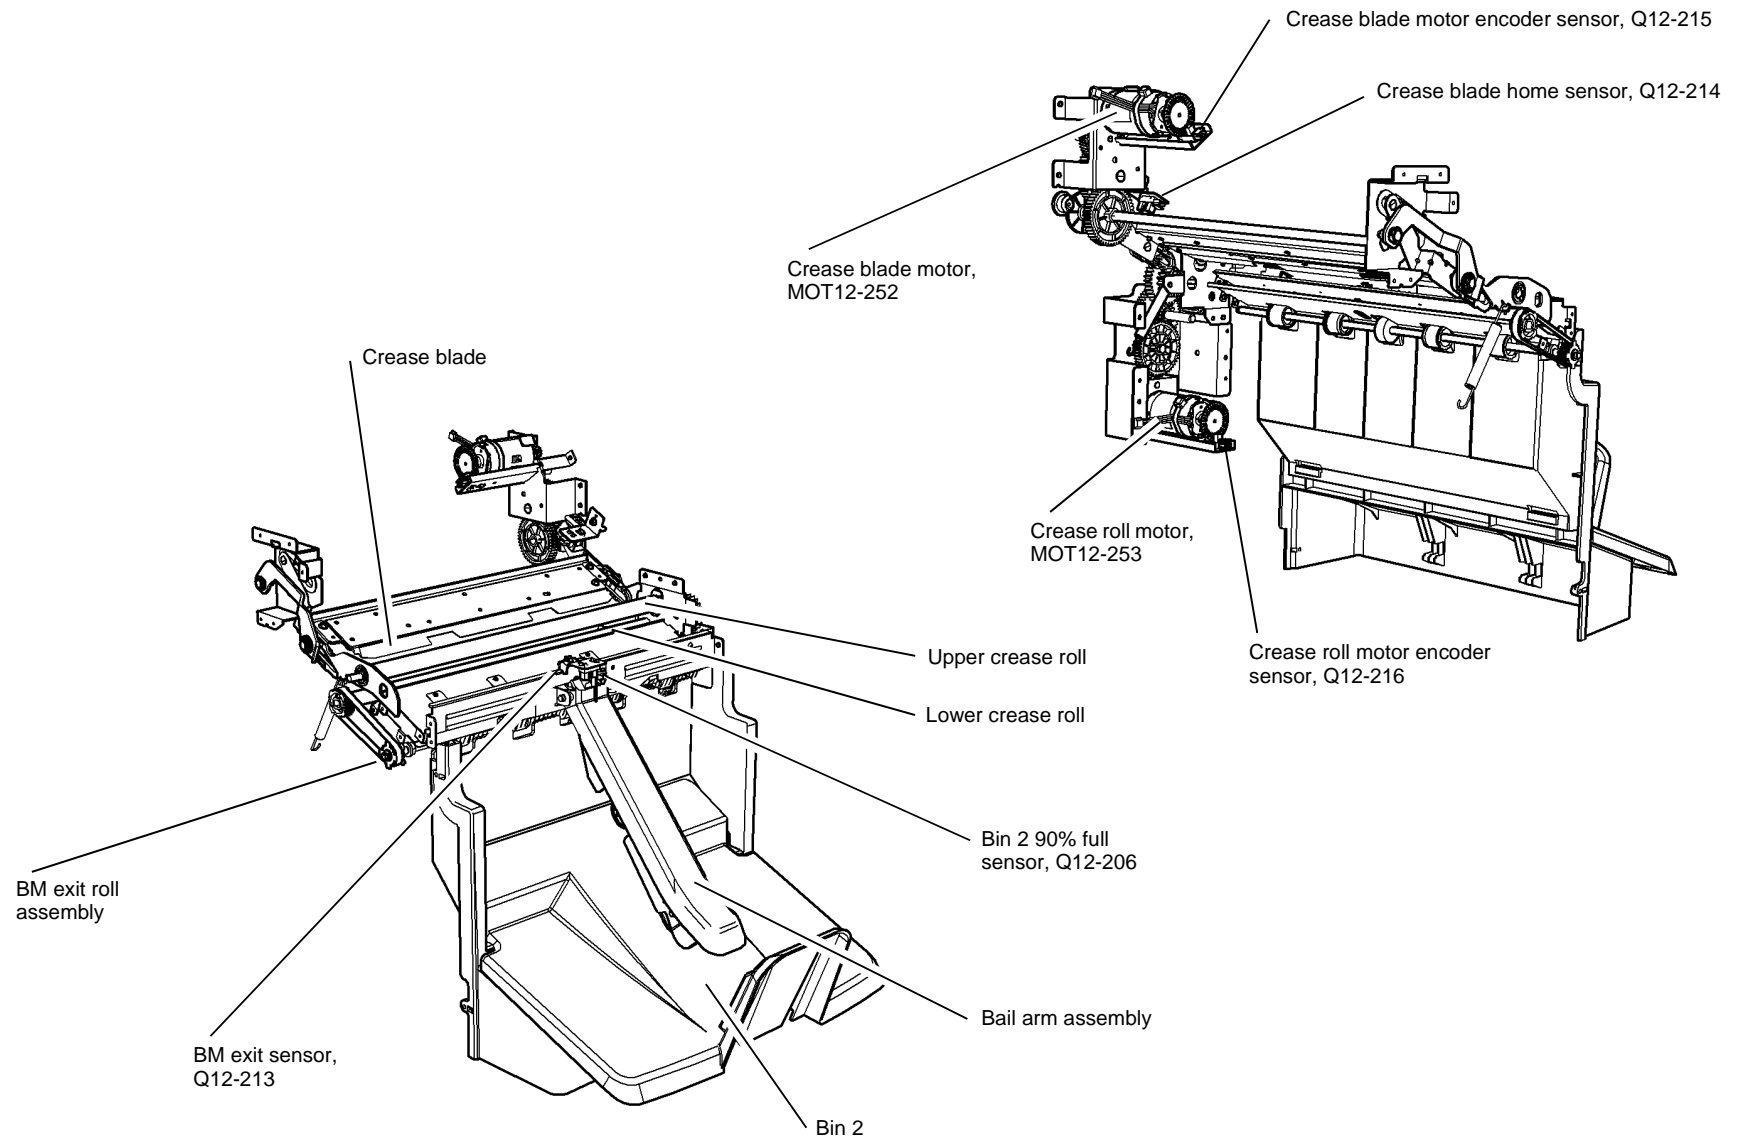
X-5-0067-A

The BM exit sensor, Q12-213, located just after the crease rolls, is also used to detect jams.

As the booklets accumulate on bin 2, they lift the bail arm assembly. The bin 2 90% full sensor, Q12-206 is actuated by a flag on the bail arm resulting in a message being displayed asking the operator to empty bin 2.

Figure 19 BM creasing components

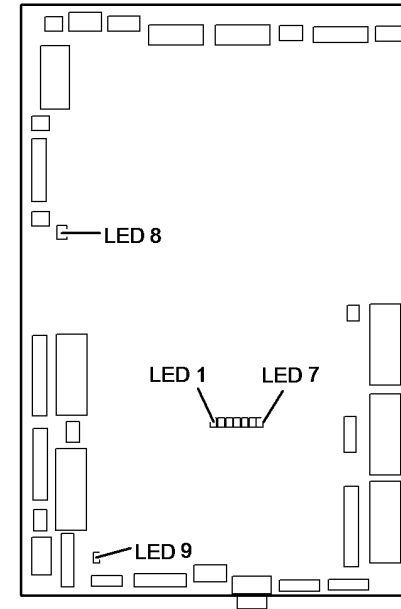
X-5-0001-A

- LED 7 - red. The LED is used during the machine production and is connected with the activity of the stacker nearly full sensor.
- LED 8 - red, steady. The indicates that the HVF top cover, front door and docking interlocks are all closed and +24V is available at the HVF module.

- LED 9 - red, steady. The LED indicates that the +5V supply is present in the HVF module.

Figure 1 LEDs on the HVF control PWB

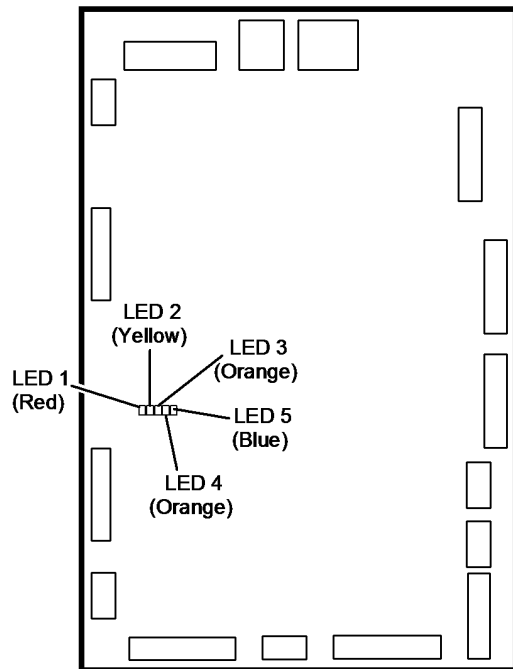
X-5-0002-A

Figure 2 shows the LEDs on the BM PWB. These are:

- LED 1 - red, steady. The LED indicates a fault or other abnormal status.
- LED 2 - yellow, flashing at about 1Hz. The LED indicates that the software is operating in normal mode. In other modes, e.g., software downloading, the flashing rate is higher.
- LED 3 - orange, steady. The LED indicates either:
 - that the tri-folder front door and top cover interlocks are closed, and +24V is available to the BM module or, if the tri-folder is not installed;
 - that the interlock cheater is present in PJ553 on the BM control PWB the logic cheater is present in PJ563 on the BM control PWB.
- LED 4 - orange, steady. The LED indicates that the +24V supply is within voltage and current limits, and that the power limiting circuit has not been active over a set time limit.
- LED 5 - blue, steady. The LED indicates that the +5V supply is present in the BM module.

Figure 2 LEDs on the BM control PWB

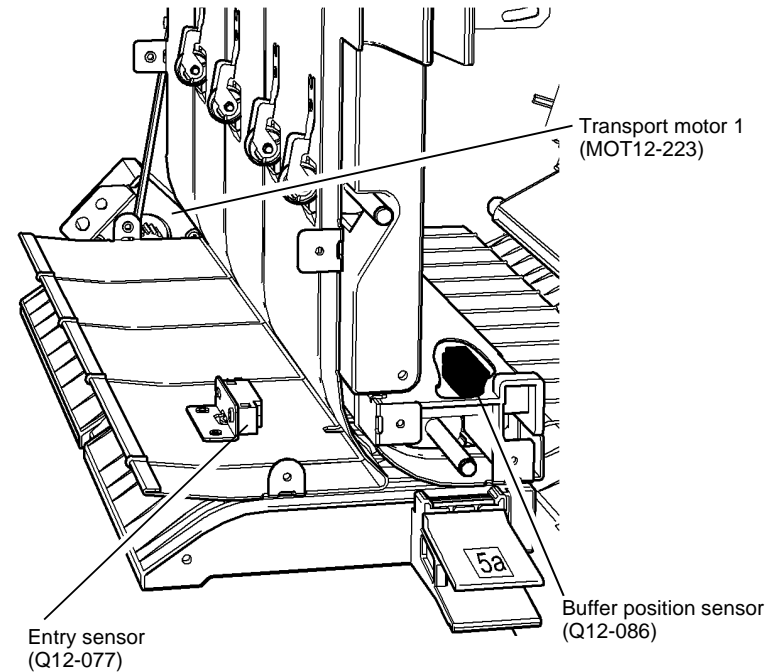
X-5-0003-A

- Entry Sensor, Q12-077. This is a reflective sensor at the HVF input transport, receiving paper from the finisher transport. Refer to Figure 3.
- Buffer position sensor, Q12-086. A reflective sensor at the end of the input transport. This senses paper fed to the hole punch and beyond, to the buffer transport. Refer to Figure 3.
- Transport motor 1, MOT12-223. This is a stepper motor, located at the rear of the HVF, and driving a toothed belt. This provides the drive to the input path from the finisher transport. It also drives the vertical paper path from the inserter and takes the paper through to the hole punch. Refer to Figure 3.

Figure 3 Entry sensor and entry feed motor

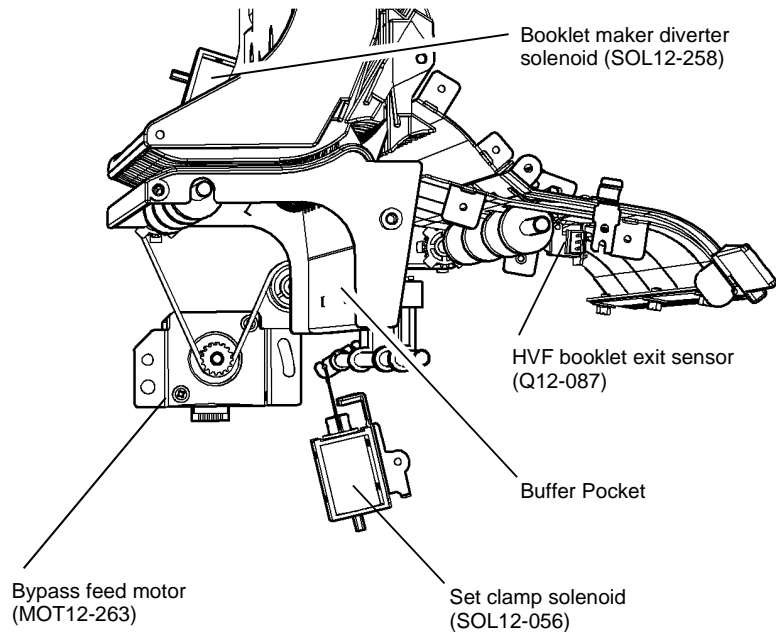
X-5-0004-A

- Booklet maker diverter solenoid, SOL12-258. Actuates to pass paper to the booklet maker. In the non-actuated condition, it allows paper to pass to the buffer transport. Refer to [Figure 4](#).

- HVF booklet exit sensor, Q12-087. A flag sensor, located in the paper guide leading to the booklet maker. It senses paper exiting the HVF for the booklet maker. Refer to [Figure 4](#).

Figure 4 Buffer area components
