708P91368
September 2017

Xerox® AltaLink® B8090 Family Multifunction Printer Service Manual

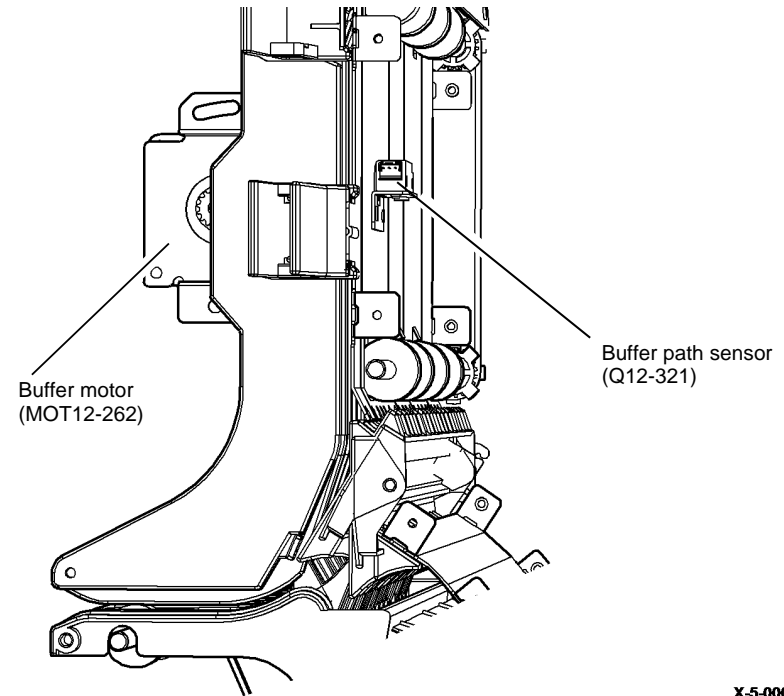
X-5-0005-A

- Buffer motor, MOT12-262. A stepper motor located at the rear of the HVF. It takes the paper from the booklet maker diverter to the top tray or stacker. Refer to [Figure 5](#).
- Buffer path sensor, Q12-321. A reflective sensor, located in the buffer transport. It senses paper being fed to the top tray or stacker. Refer to [Figure 5](#).

Figure 5 Buffer motor and buffer path sensor

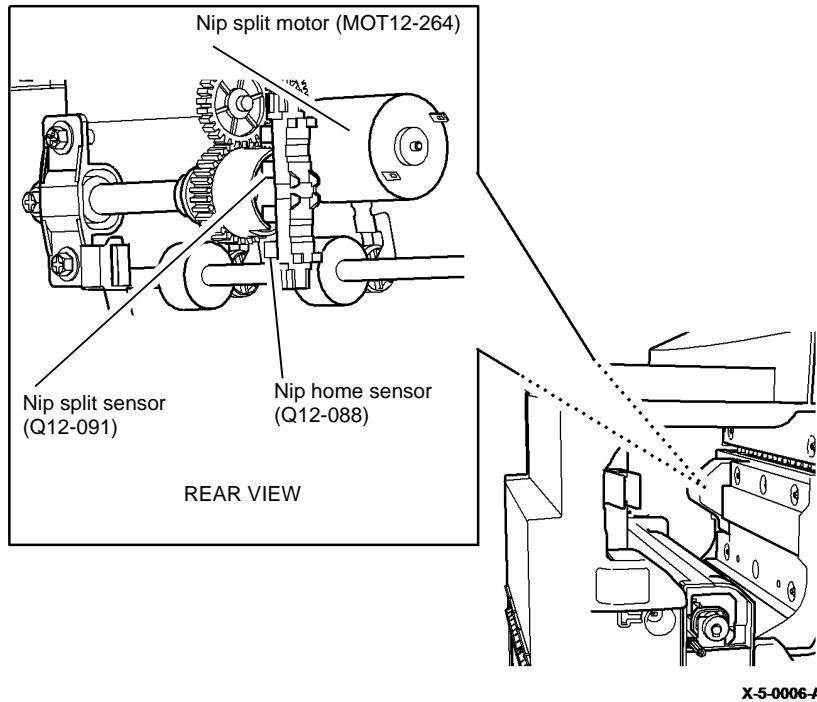
- Nip split motor, MOT12-264. A DC motor, located in a housing at the rear of the 5b jam clearance guide. It opens the nip in the vertical buffer path by moving the idler rolls to the left, away from the paper. This allows the first sheet of a multi-sheet compiled job, to drop into the buffer pocket, as explained in the 'Buffer clamp solenoid' bulleted item, above. Refer to [Figure 6](#).
- Nip split sensor, Q12-091. A flag sensor, operated by a cylindrical flag on the nip split cam shaft. It senses the open position of the nip. Refer to [Figure 6](#).
- Nip home sensor, Q12-088. A flag sensor, operated by a cylindrical flag on the nip split cam shaft. It senses the closed position of the nip. Refer to [Figure 6](#).

Figure 6 Nip split mechanism

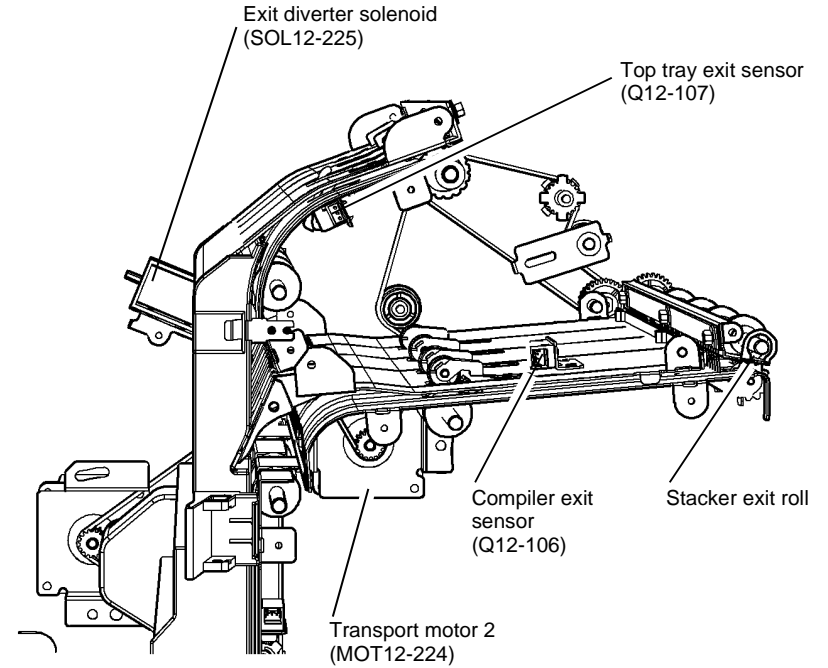
- Transport motor 2, MOT12-224. A stepper motor, located at the rear of the HVF and driving two toothed belts. It takes the paper from the exit diverter and feeds it either to the top tray, via the top exit sensor, or to the stacker, via the stacker exit sensor. Refer to [Figure 7](#).
- Exit diverter solenoid, SOL12-225. Actuates to divert the paper from the buffer to the top tray. In the non-actuated condition, it allows the paper to pass to the stacker. Refer to [Figure 7](#).
- Top tray exit sensor, Q12-107. A flag sensor located in the upper exit paper guide. It senses paper passing out to the top tray. Refer to [Figure 7](#).

- Compiler exit sensor, Q12-106. A reflective sensor located on the top jam clearance paper guide. It senses paper passing out to the stacker. Refer to [Figure 7](#).

Figure 7 Top tray and stacker components

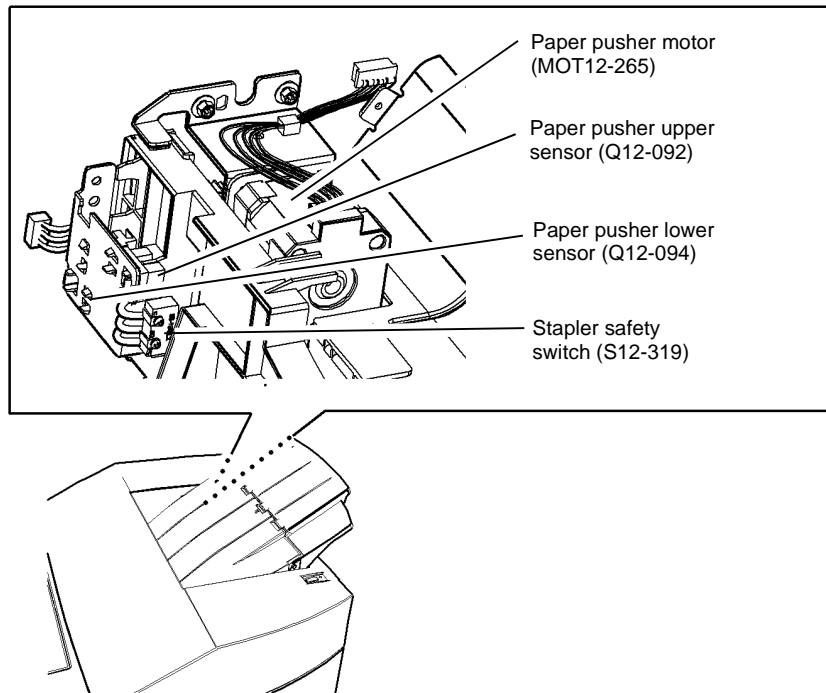
X-5-0008-A

Upper Paddle: As the paper pusher moves down with the first sheet, the paddle unit moves to the lower position. As the paper pusher returns to the upper position, ready for the next sheet, the paddles rotate to position the first sheet correctly in the ejector. The sheet is correctly positioned when its trailing edge is in contact with the upright posts in the stapler module.

The number of cycles the paddle rotates depends on the size and orientation of the paper. The paddle unit remains in the lower position and every sheet in the set is positioned in this way. When the final sheet in the set has been positioned by the paddle, the paddle unit returns to the upper position.

Figure 8 Paper pusher components

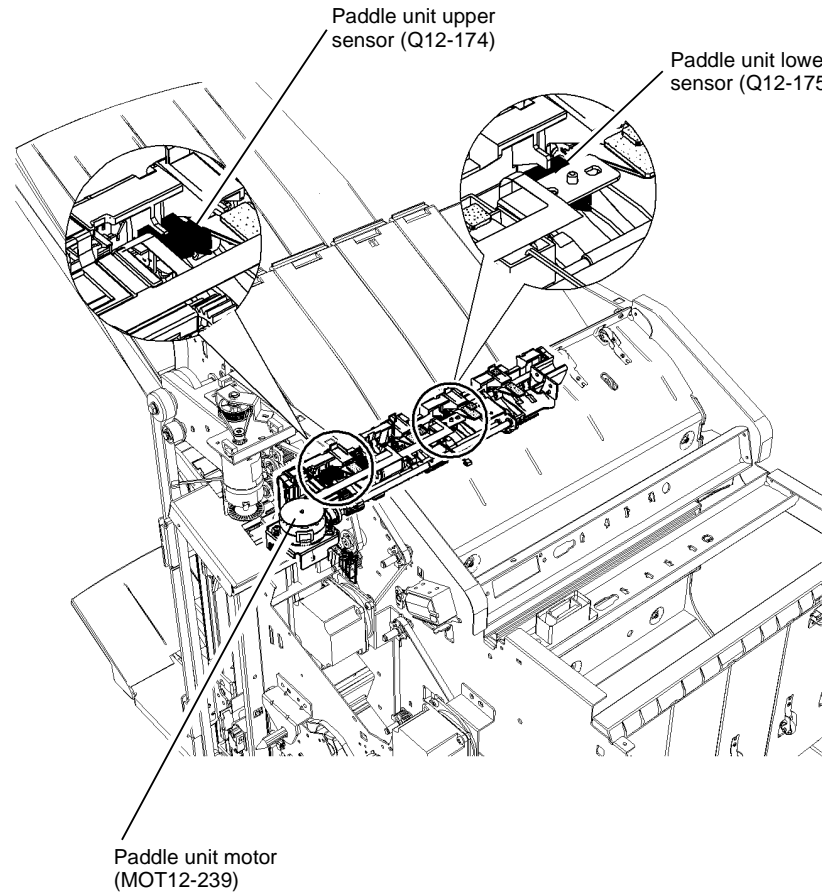
X-5-0009-A

- Paddle unit motor, MOT12-239. A stepper motor located on the rear frame. It drives the paddle unit down to the working position and back up at the end of each set. Refer to [Figure 9](#).
- Paddle unit lower sensor, Q12-175. A flag sensor located on a bracket beside the paddle unit, and sensing the paddle unit in the lower position. Refer to [Figure 9](#).
- Paddle unit upper sensor, Q12-174. A flag sensor located on a bracket beside the paddle unit, and sensing the paddle unit in the upper position. Refer to [Figure 9](#).

Figure 9 Paddle unit components

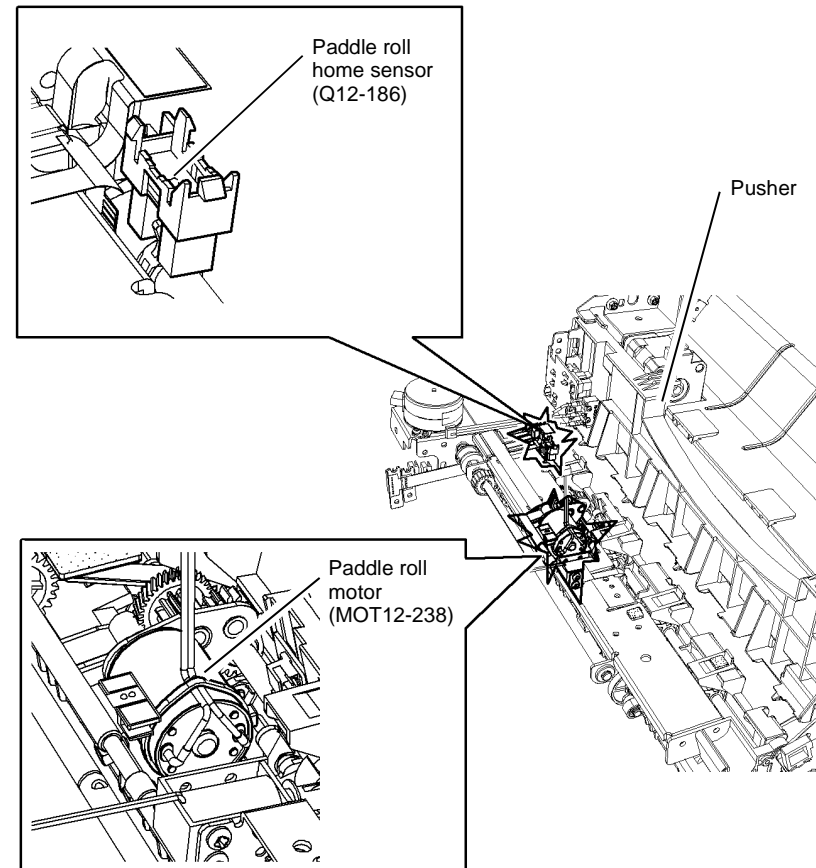
X-5-0010-A

- Paddle roll motor, MOT12-238. A DC motor located in the paddle unit. The paddle is turned one complete revolution. Refer to [Figure 10](#).
- Paddle roll home sensor, Q12-186. A flag sensor located in the paddle unit, sensing the paddle roller in the home position. Refer to [Figure 10](#).

Figure 10 Paddle roller components

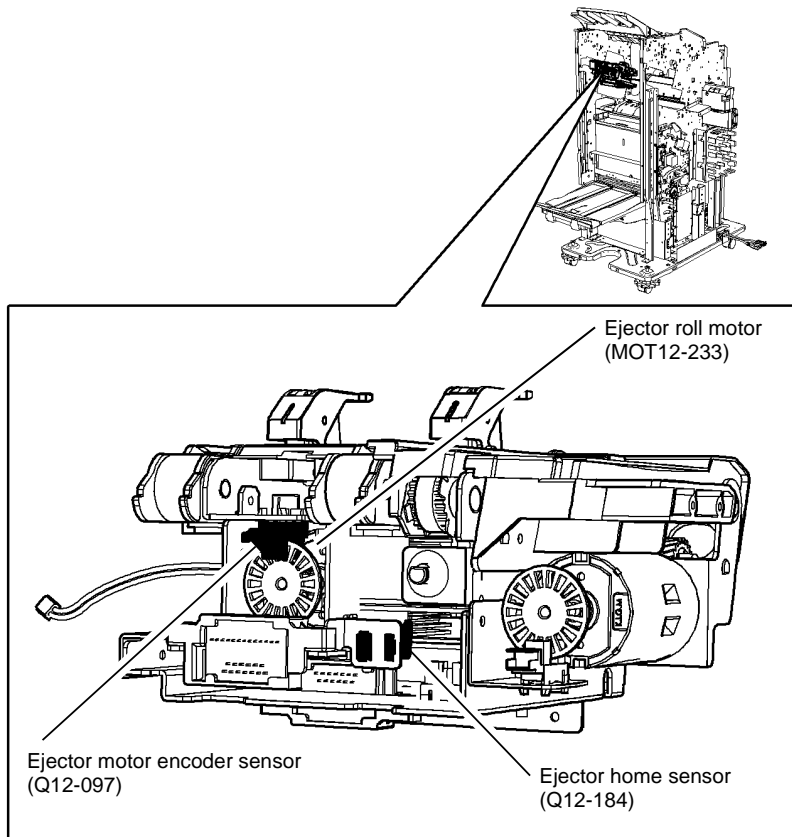
- Ejector roll motor, MOT12-233. A DC motor located at the rear underside of the ejector unit. It runs in the reverse direction to rotate the lower paddle. Refer to [Figure 11](#).
- Ejector roll motor encoder sensor, Q12-097. A normal flag type encoder sensor, sensing the motor rotation. Refer to [Figure 11](#).
- Ejector home sensor, Q12-184. A normal flag type sensor, sensing the ejector home. Refer to [Figure 11](#).

Figure 11 Ejector roll motor and sensors

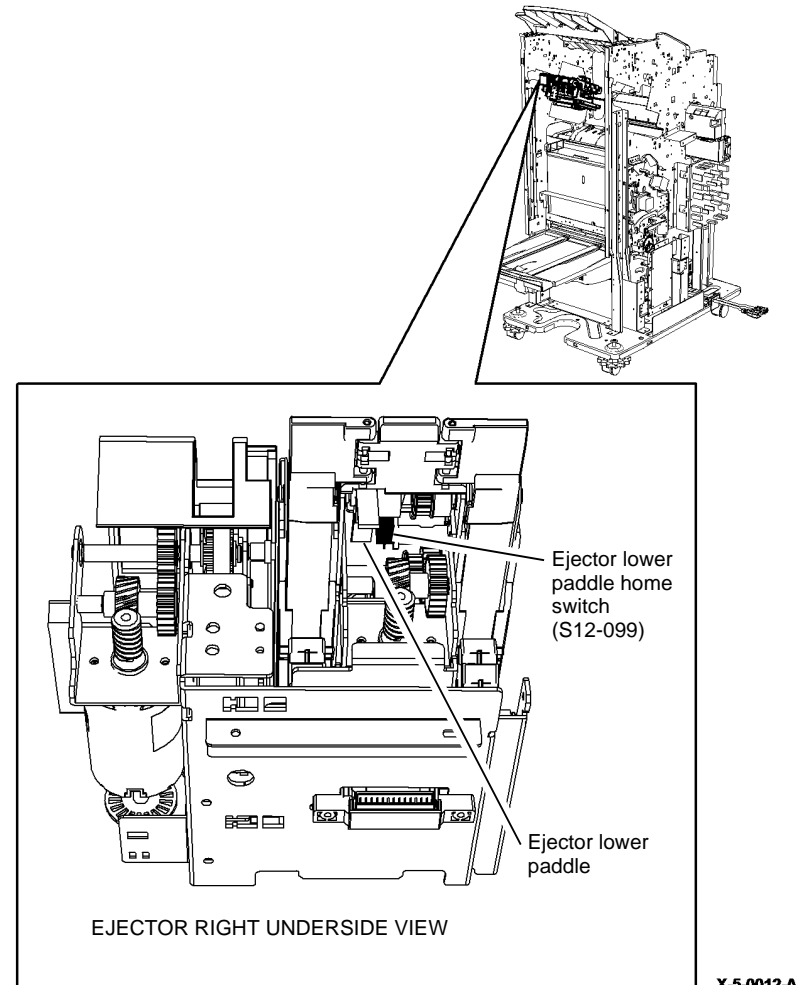
- Ejector lower paddle home switch, S12-099. A micro switch located at the front underside of the ejector unit, sensing the home position of the lower paddle. This switch allows the paddle to rotate for one complete cycle. Refer to [Figure 12](#).

Figure 12 Ejector lower paddle and home sensor

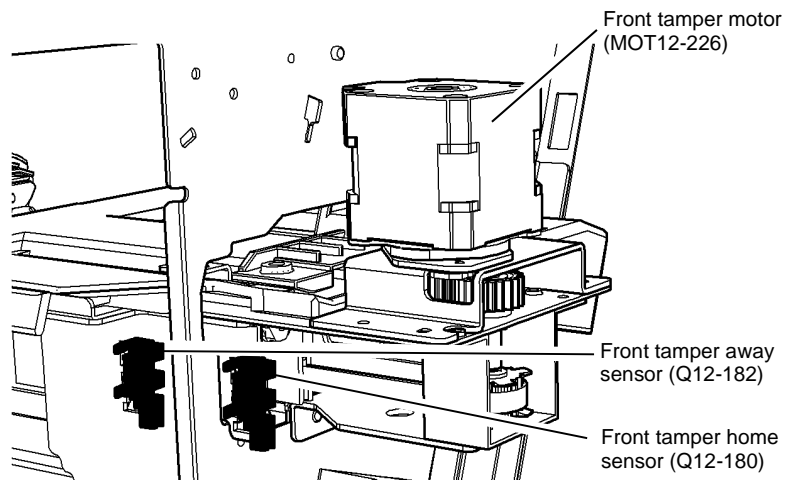
X-5-0013-A

- Front tamper motor, MOT12-226. A DC motor, located above the bracket on the front frame. This motor moves the front tamper to the away and home positions. Refer to [Figure 13](#).
- Front tamper home sensor, Q12-180. A flag sensor, located under the bracket on the front frame. This sensor detects the front tamper in the home position. Refer to [Figure 13](#).
- Front tamper away sensor, Q12-182. A flag sensor, located under the bracket on the front frame. This sensor detects the front tamper in the away position. Refer to [Figure 13](#).

Figure 13 Front tamper components

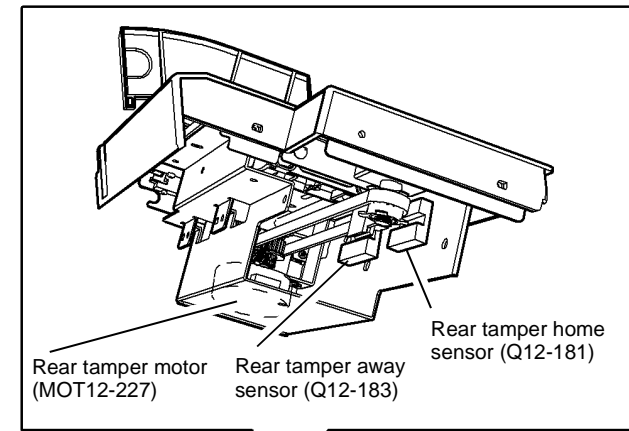
- Rear tamper motor, MOT12-227. A stepper motor, located immediately to the rear of the ejector unit. This motor moves the rear tamper between the rear and home positions. Refer to [Figure 14](#).
- Rear tamper home sensor, Q12-181. A flag sensor, located to the rear of the rear tamper motor. This sensor detects the rear tamper in the home position. Refer to [Figure 14](#).
- Rear tamper away sensor, Q12-183. A flag sensor, located to the rear of the rear home sensor. This sensor detects the rear tamper in the away position. Refer to [Figure 14](#).

Figure 14 Rear tamper components

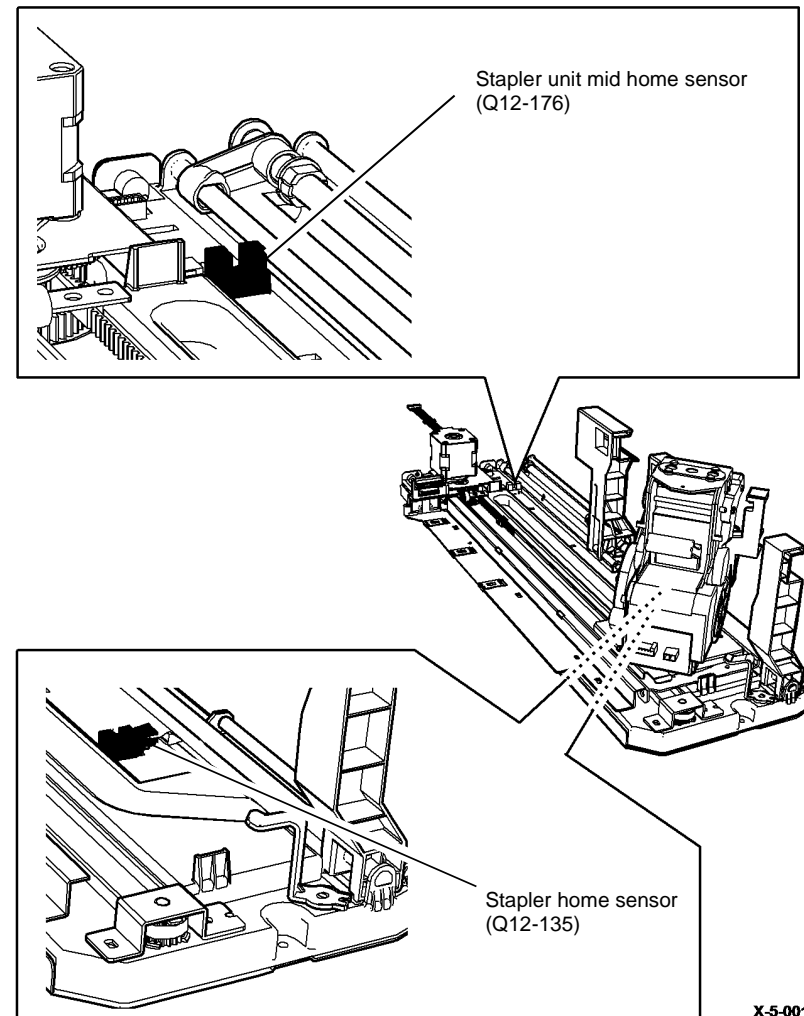
- Stapler home sensor, Q12-135. A flag sensor, located at the outboard end of the bed of the stapler unit. It detects the stapler unit in the home position. Refer to [Figure 15](#).

- Stapler unit mid home sensor, Q12-176. A flag sensor, located towards the inboard end of the bed of the stapler module. It detects the stapler at the inboard end of its travel. Refer to [Figure 15](#).

Figure 15 Stapling components

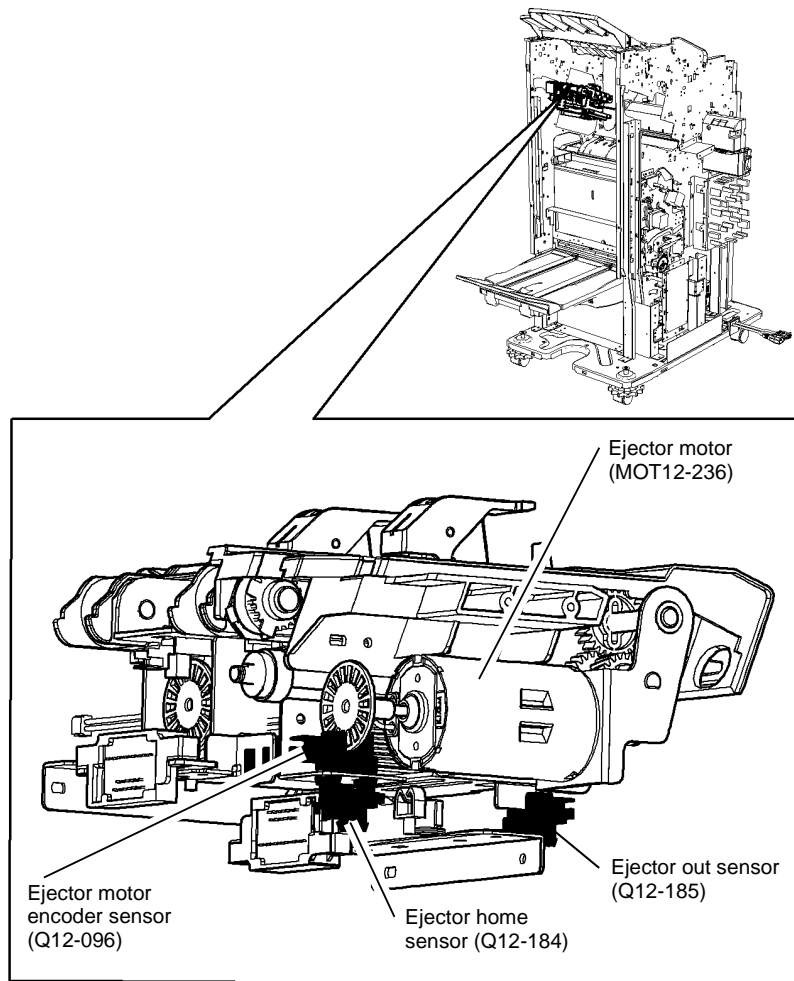
Figure 16 Ejector unit components

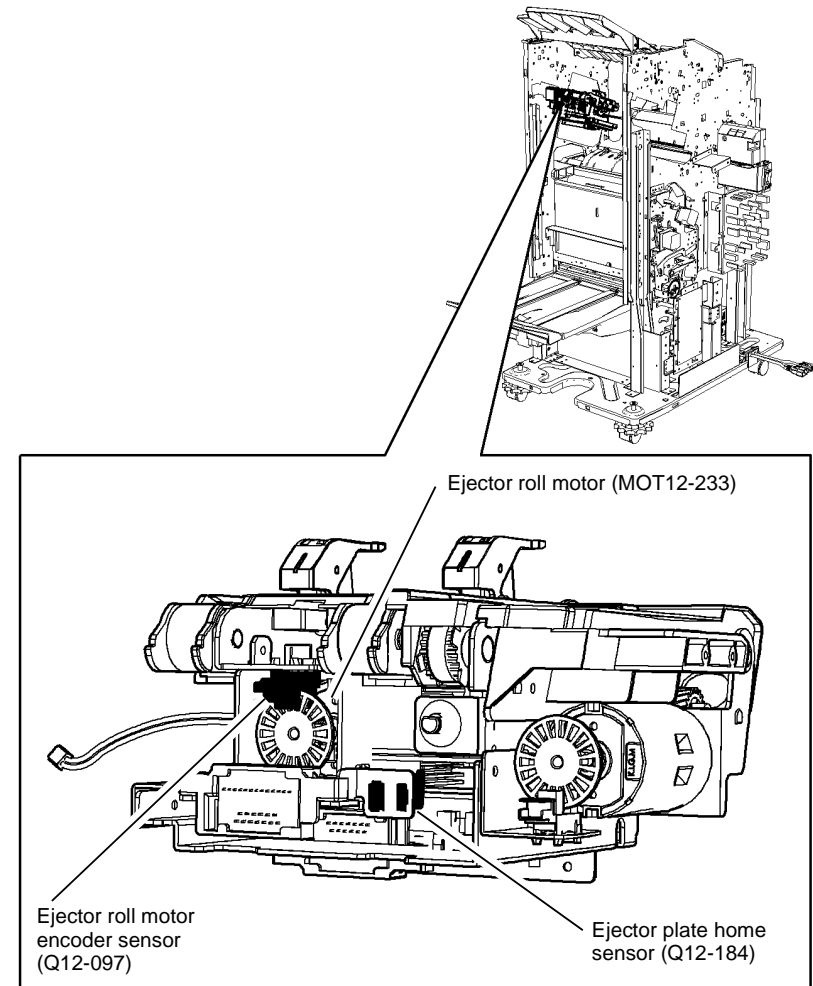
- Ejector roll encoder sensor, Q12-097. A flag sensor located at the rear of the ejector roll motor. This senses the movement of the ejector roll motor. Refer to [Figure 17](#).

- Ejector home sensor, Q12-184. A flag sensor, located at the rear of the ejector assembly, under the ejector belt. This detects the eject fingers in the home position. Refer to [Figure 17](#).

Figure 17 Ejector roll components

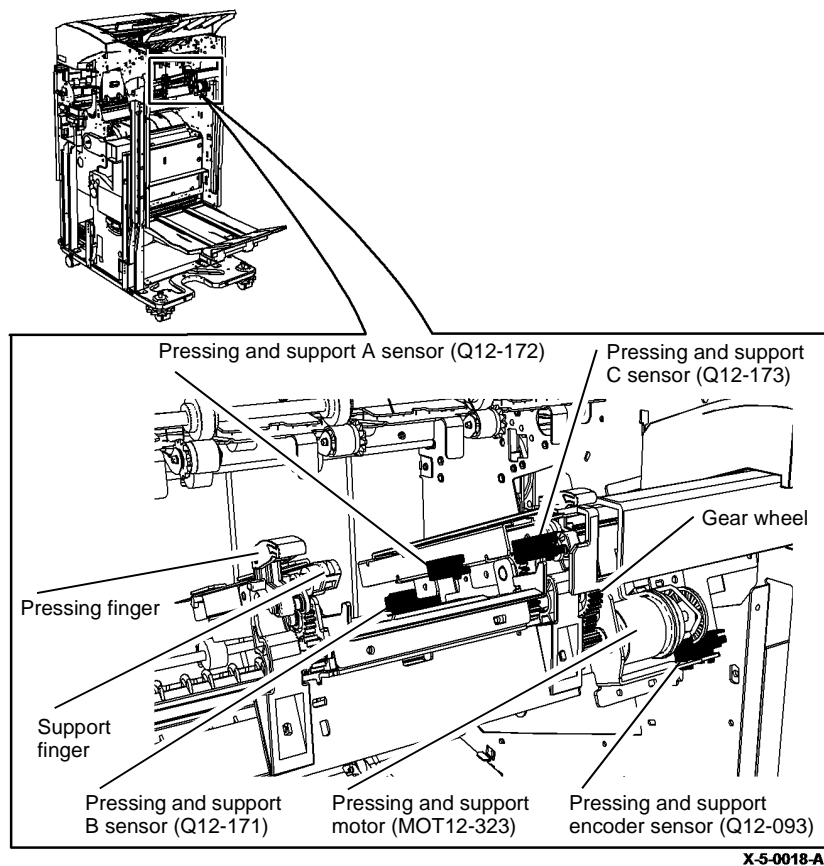
- Pressing and support A sensor, Q12-172. A flag sensor, detecting the support fingers in the 'home' position. Refer to [Figure 18](#).
- Pressing and support B sensor, Q12-171. A flag sensor, detecting the support fingers in the 'init' position. Refer to [Figure 18](#).

- Pressing and support C sensor, Q12-173. A flag sensor, detecting the support fingers in the 'out' position. Refer to [Figure 18](#).

Figure 18 Ejector roll components

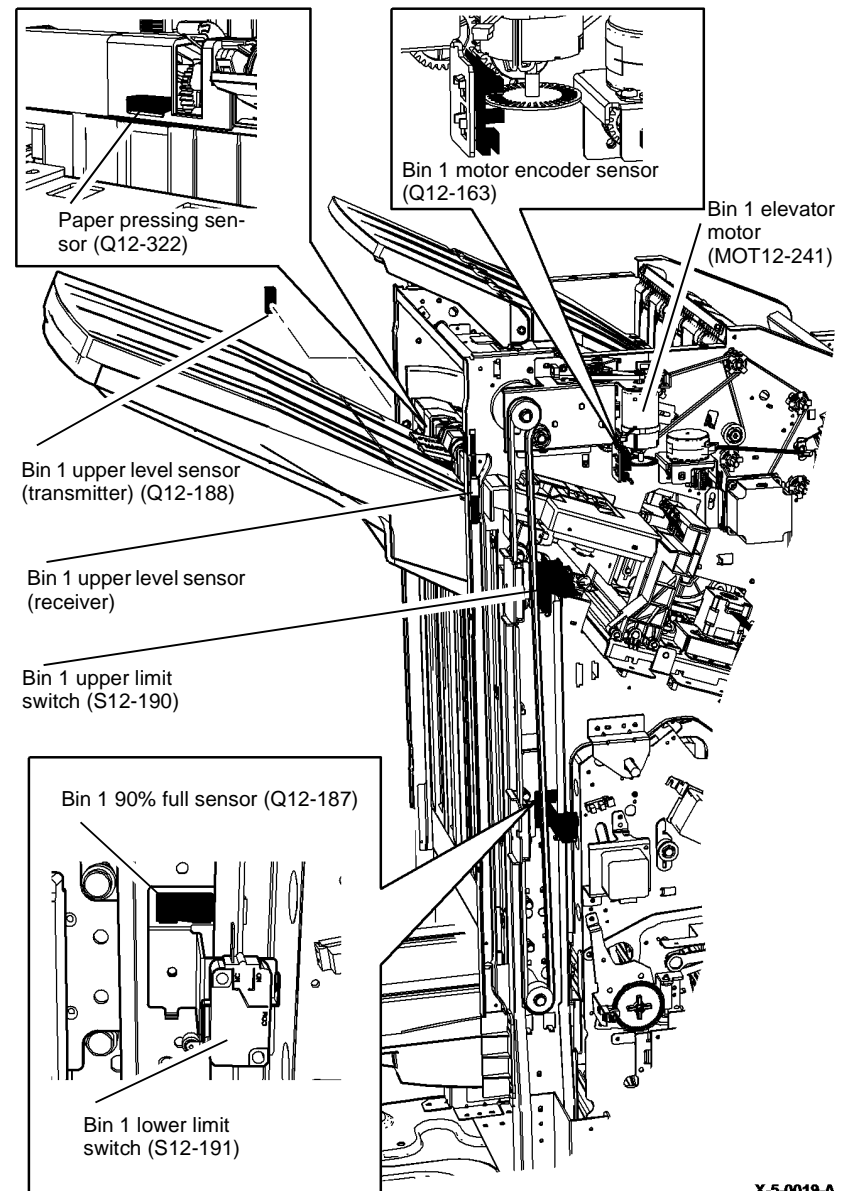
- Bin 1 upper limit switch, S12-190. A micro switch, located on the rear frame. This switch is actuated when the tray is above its normal level of operation. When this switch is actuated, the reverse, upwards, direction of the elevator motor is disabled, but the motor is allowed to drive the stack down. Refer to [Figure 19](#).

- Bin 1 lower limit switch, S12-191. A micro switch, located on the rear frame and mounted on the same bracket as the 90% full sensor. The switch is actuated when the tray is at its lowest allowable limit of operation. When this switch is actuated, the forwards, downwards, direction of the elevator motor is disabled, but the motor is allowed to drive the stack up. Refer to [Figure 19](#).

Figure 19 Stacker components

The bin 1 upper limit switch, S12-190 and bin 1 lower limit switch, S12-191 are positioned to monitor any over travel of bin 1. They will remove the +24V supply to the bin 1 elevator motor, MOT12-241 if over travel occurs due to component failure.

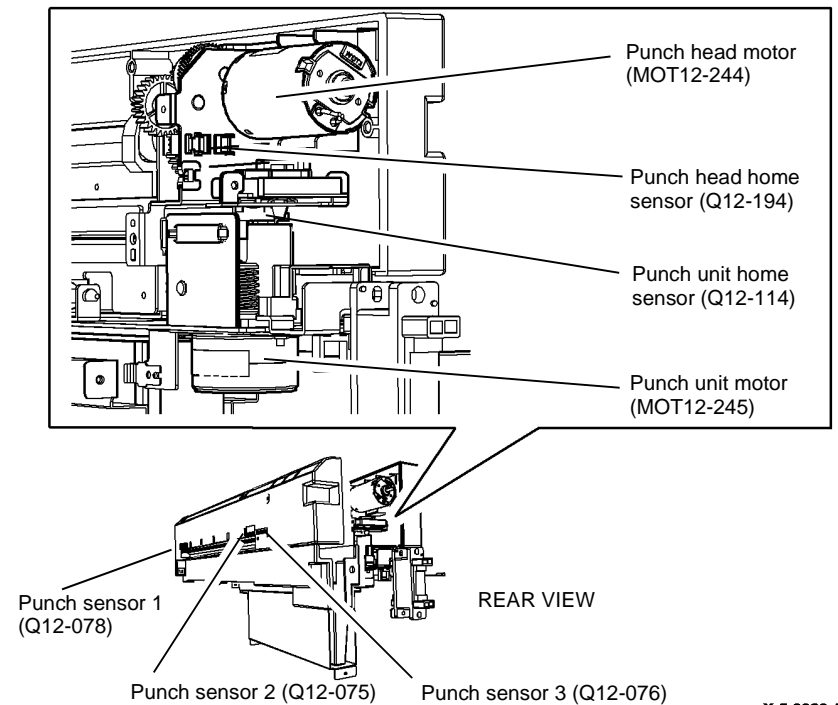
- Punch sensor 2, Q12-075. A reflective sensor, detecting the rear, (inboard), edge of 8.5 x 11 inch SE fed paper. The punch unit motor MOT12-245, drives the punch unit forwards until the paper edge is detected. The punch unit is then in the correct position for the punch head to operate. Refer to [Figure 20](#).

- Punch sensor 3, Q12-076. A reflective sensor, detecting the rear, (inboard), edge of A4 LE fed paper. The punch unit motor drives the punch unit forwards until the paper edge is detected. The punch unit is then in the correct position for the punch head to operate. Refer to [Figure 20](#).

Figure 20 Hole punch components

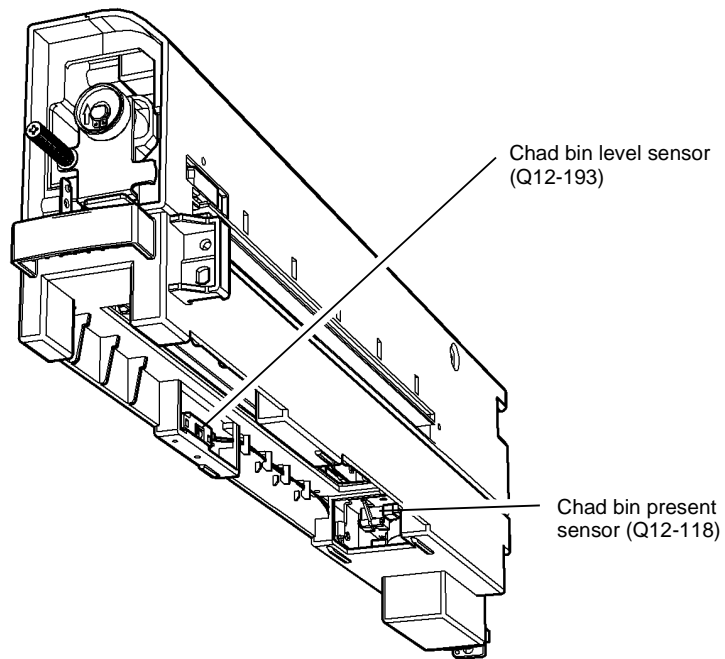
- Chad bin present sensor, Q12-118. A flag sensor, detecting the presence of a chad bin, under the hole punch module. Refer to [Figure 21](#).
- Chad bin level sensor, Q12-193. A reflective sensor, detecting the presence of chad, through a hole, high in the side of the chad bin. Refer to [Figure 21](#).

Figure 21 Chad bin components

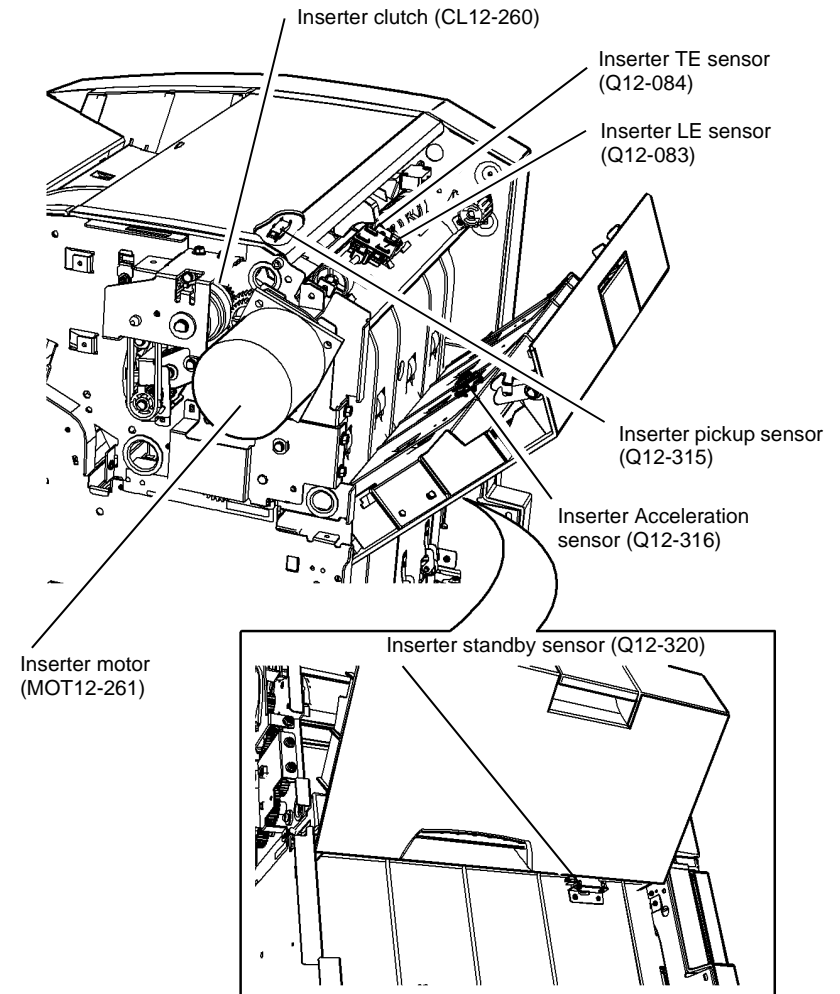
- Inserter acceleration sensor, Q12-316. A reflective sensor, located behind the inserter left hand door. This sensor detects the leading edge of the sheet and operates together with the inserter LE sensor, to determine the speed of the paper. When the speed has been measured, the information is used to control the speed of the inserter motor. Refer to [Figure 22](#).

- Inserter standby sensor, Q12-320. A reflective sensor, located on the HVF vertical transport, below the inserter. It senses the leading edge of the sheet passing into the HVF from the inserter and provides the final go/wait information, for feeding the sheet into the HVF at the correct inter-document gap (IDG). Refer to [Figure 22](#).

Figure 22 Inserter paper path components

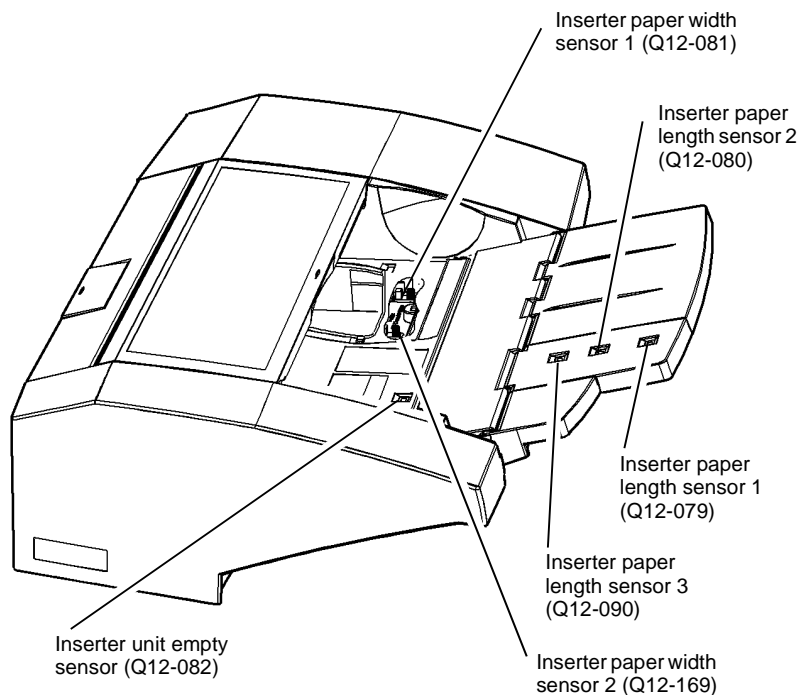
- Inserter paper width sensor 1, Q12-081. The detector incorporates two width sensors. Width sensor 1 is a flag sensor, actuated by the paper width guide position. The sensor changes state at 285mm, (11 1/4 inches) and 210mm, (8 1/4 inches) paper widths. Refer to [Figure 23](#).

- Inserter paper width sensor 2, Q12-169. A flag sensor, actuated by the paper width guide position. The sensor changes state at 273mm, (10 3/4 inches) paper width. Refer to [Figure 23](#).

Figure 23 Inserter paper sensors

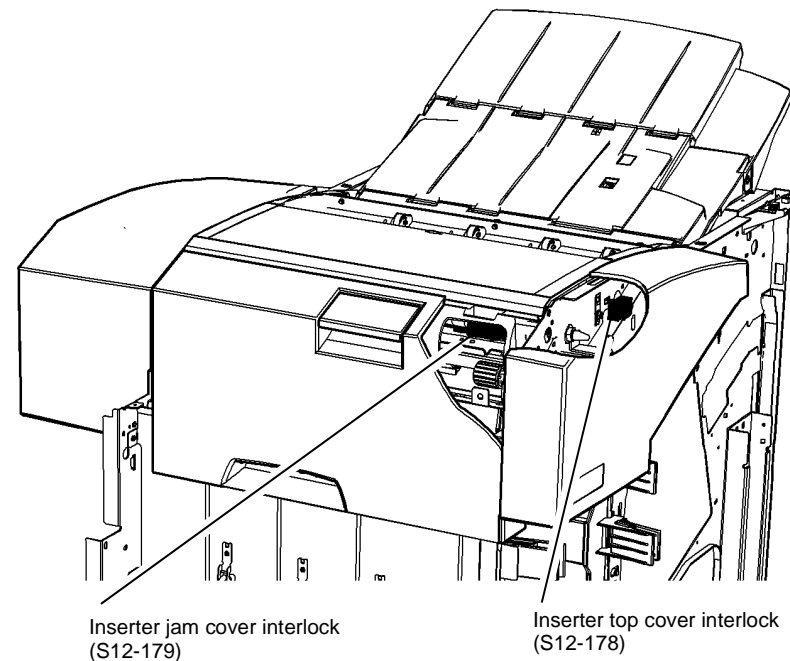
- Inserter jam cover interlock, S12-179. A micro switch, located behind the top inside cover. This switch is wired in series with the inserter top cover interlock, to supply +24V to the inserter. When both interlocks are closed, the +24V LED on the inserter PWB is lit. Refer to [Figure 24](#).
- Inserter top cover interlock, S12-178. A micro switch, located behind the front cover. This switch is wired in series with the inserter left hand door interlock, to supply +24V to the inserter. When both interlocks are closed, the +24V LED on the inserter PWB is lit. Refer to [Figure 24](#).

Figure 24 Inserter interlocks

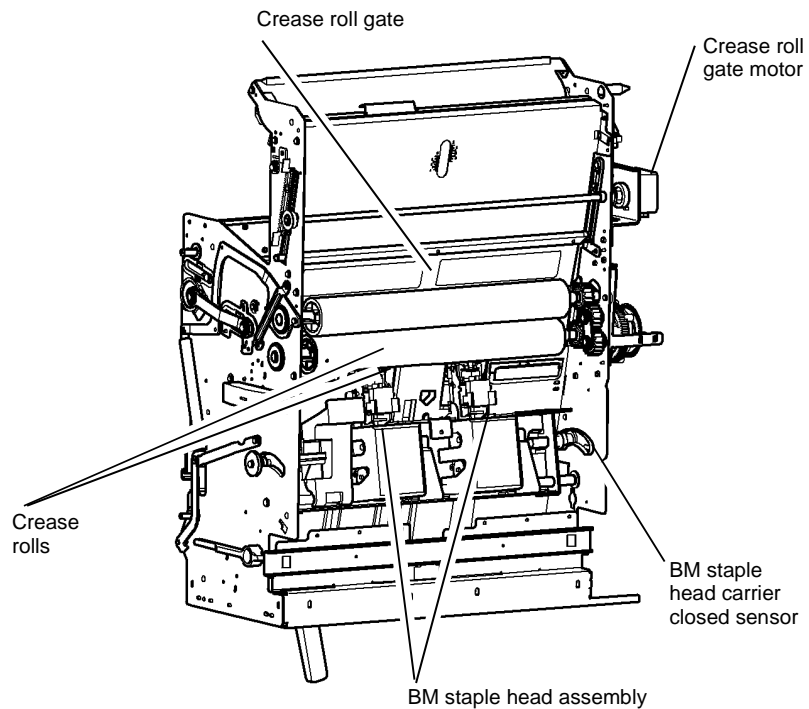
The BM compiler motor, MOT12-251 is driven at host speed and provides mechanical drive to the BM entry roll nip.

Figure 25 Booklet maker module components (1)

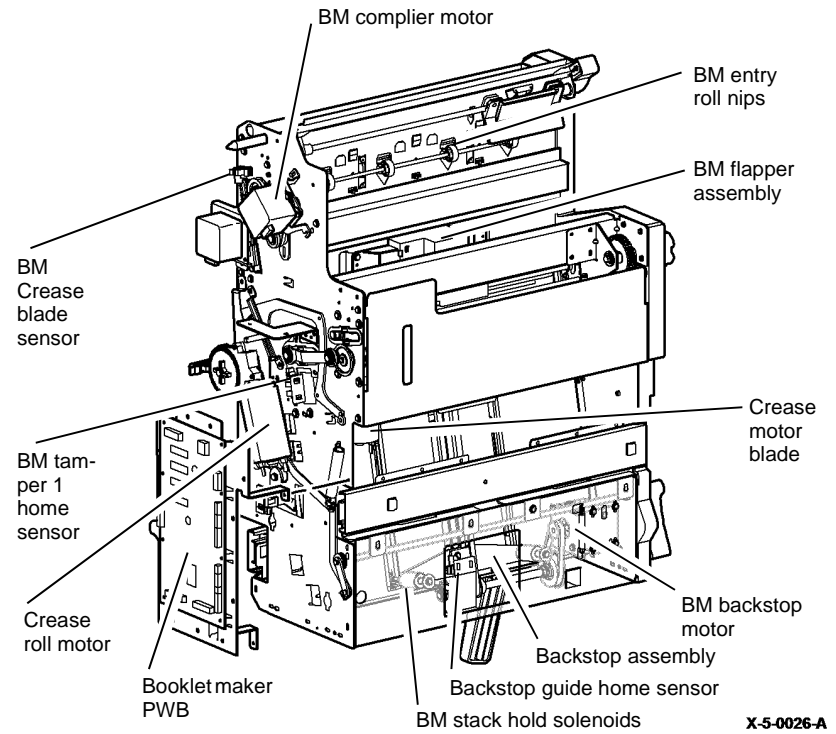
Figure 26 Booklet maker module components (2)

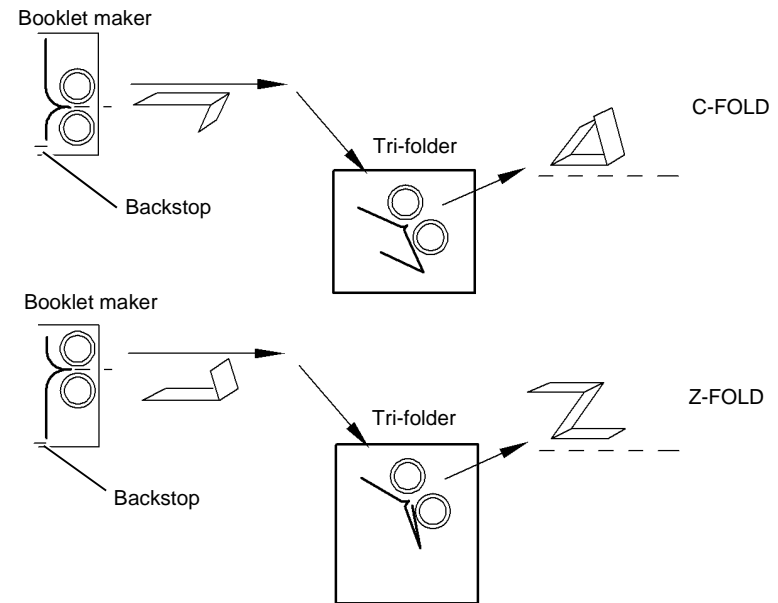
Figure 27 shows how the C-folds and the Z-folds are formed. The difference lies in where the first fold is made in the sheet, by the booklet maker. For a C-fold, the backstop is raised to produce a fold near the leading edge of the sheet. For a Z-fold, the backstop is lowered to produce a fold near the trailing edge of the sheet, effectively inverting the sheet.

Figure 27 C and Z folds

The tri-folder works in conjunction with the booklet maker, to produce 'C' or 'Z' folds. The booklet maker makes the first fold, and passes the sheet to the tri-folder to make the second fold. One sheet at a time is folded, and the tri-folder can fold 60-120gsm, (15-30lbs) sheets.

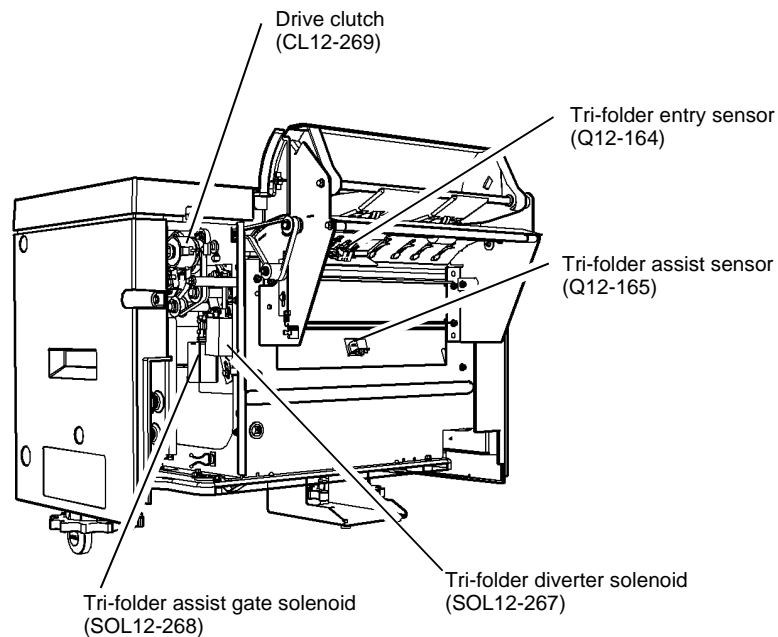
- Tri-folder assist gate sensor, Q12-165. A flag sensor, located in the roller assembly, and is mounted on the adjustable backstop plate. This sensor detects the sheet entering the roller assembly to be folded. Refer to [Figure 28](#).

- Tri-folder assist gate solenoid, SOL12-268. The solenoid is located at the rear of the tri-folder. The assist gate solenoid is only actuated during C-folds, to assist the first folded flap into the crease rolls. It actuates as the sheet enters the crease rolls and ensures that the trailing edge of the first fold stays inside the crease of the second fold. Refer to [Figure 28](#).

Figure 28 Entry sensor and folding components

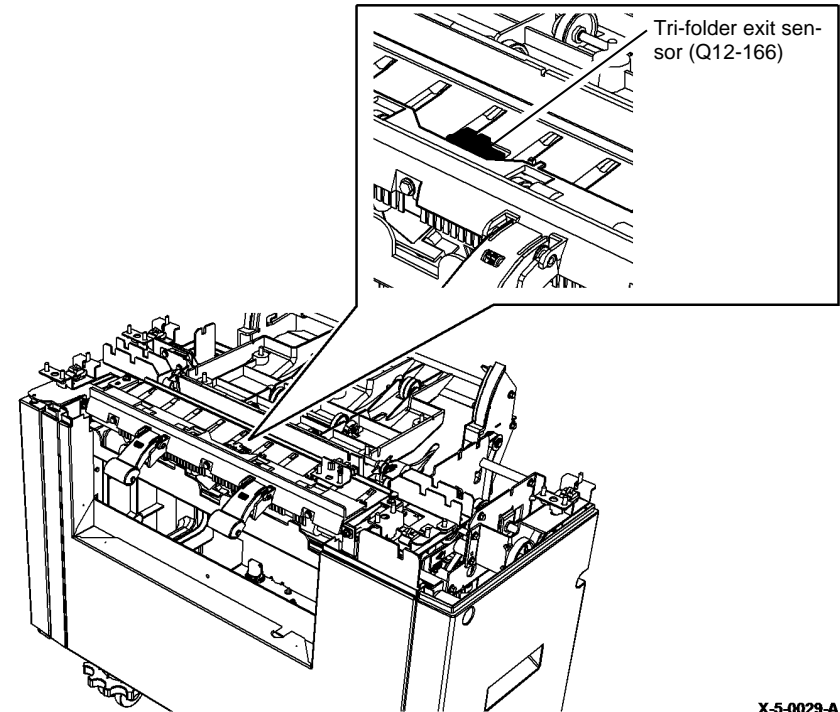
- Tri-folder exit sensor, Q12-166. A flag sensor, located in the exit paper guide. This sensor detects the sheets as they leave the tri-folder. Refer to [Figure 29](#).

Figure 29 Tri-folder exit sensor

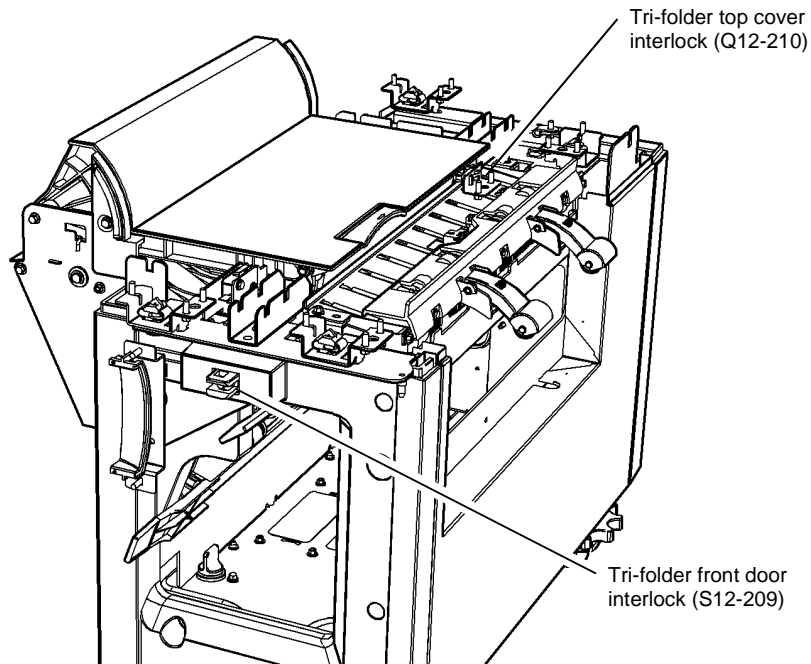
- Tri-folder top cover interlock switch, S12-209. A single-pole micro switch, located at the front of the tri-folder. This switch is connected in series with the front door interlock switch, S12-209. When both switches are made, the +24V supply is fed to the tri-folder PWB and the BM PWB. The BM PWB has +24V LED indication, as described in [Power/Interlocks](#). Refer to [Figure 30](#).

- Tri-folder top cover interlock sensor, Q12-210. A flag sensor, located towards the rear of the tri-folder top cover. This sensor detects whether the top cover is open or closed. Refer to [Figure 30](#).

- Tri-folder front door interlock switch, S12-209. A double-pole switch, located behind the top of the tri-folder front door. One pole of this switch is connected in series with the tri-folder top cover interlock switch. When both switches are made, the +24V supply is fed to the tri-folder PWB and the BM PWB. The second pole of this switch detects whether the tri-folder front door is open or closed. Refer to [Figure 30](#).

Figure 30 Tri folder interlock components

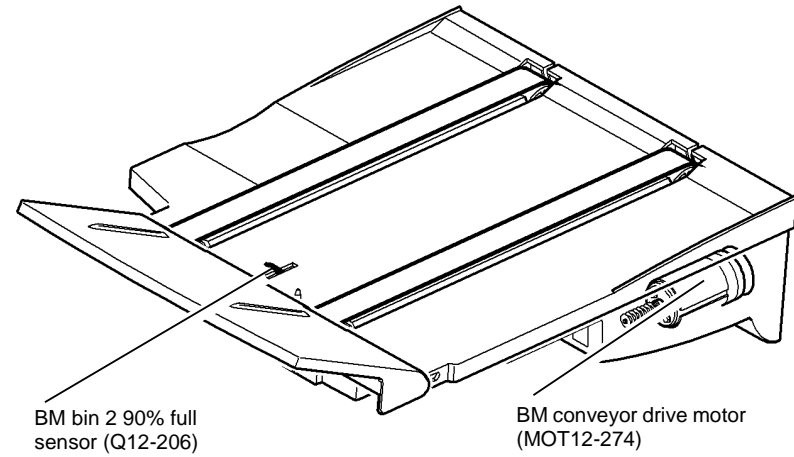
- BM conveyor drive motor, MOT12-274. A stepper motor, driving the conveyer belts. Refer to [Figure 31](#).
- Bin 2 90% full sensor, Q12-206. A flag sensor, detecting a nearly-full tray. Refer to [Figure 31](#).

Figure 31 Bin 2 components

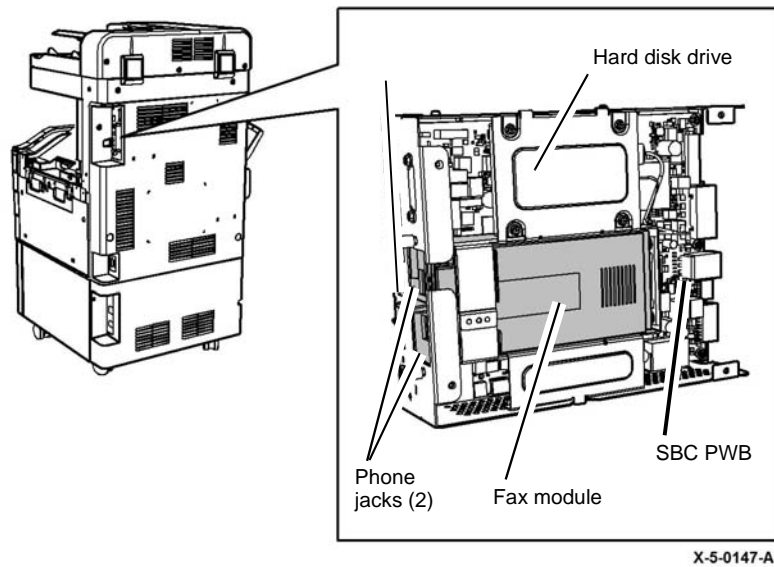
The fax PWB is fitted with either one or two MultiTech MT9234SMI modems. The PWB supports fax modem reset control, presence indicator, audio volume control and board revision information. The Fax PWB is connected directly to the SCB PWB, and is controlled by software running on the SBC PWB.

Figure 1 Fax location

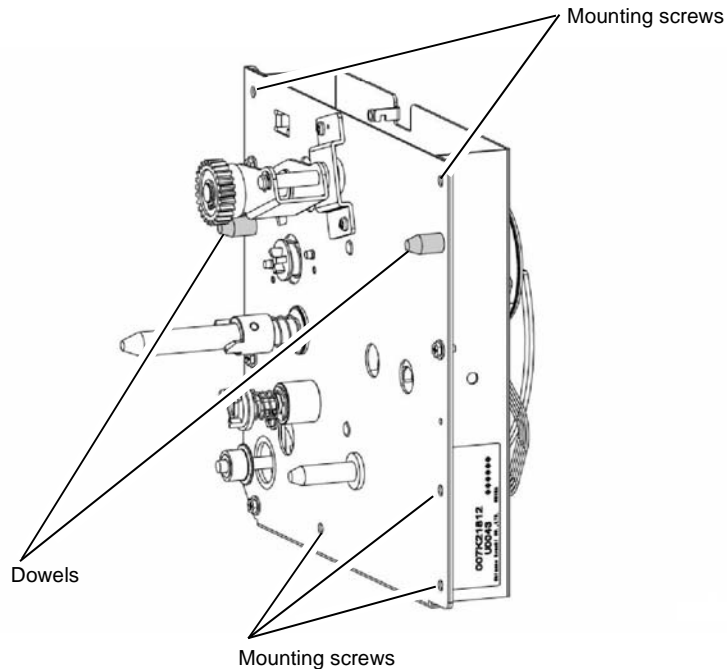
Refer to [Figure 1](#). The main drive module is mounted directly to the rear frame of the IOT and is located by 2 dowels and secured by 6 screws.

Figure 1 Main Drive Module mounting

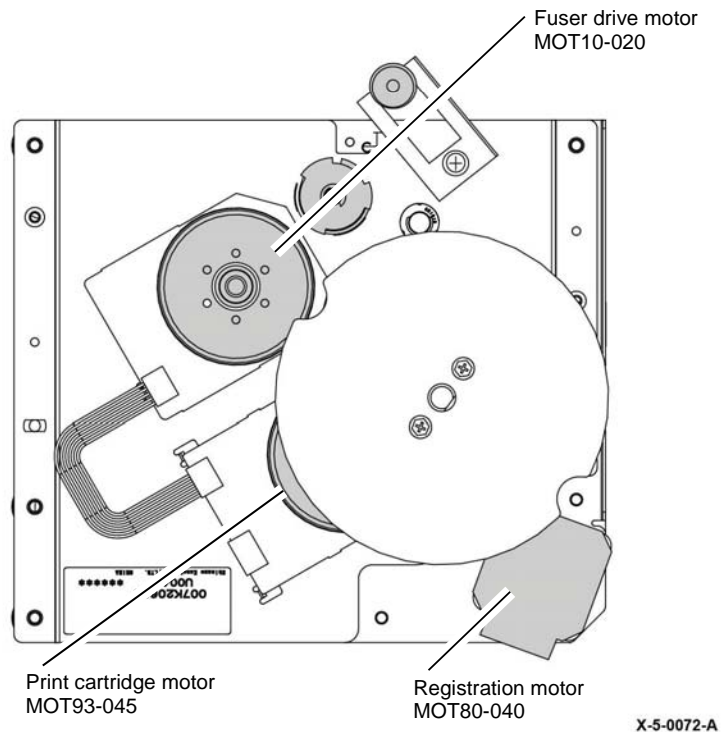
Figure 3 shows the location of the main drive motors in the main drive module. The main drive module on the AltaLink® B8045/B8055 and the AltaLink® B8065/B8075/B8090 variants are visually identical.

Figure 3 Main drive module

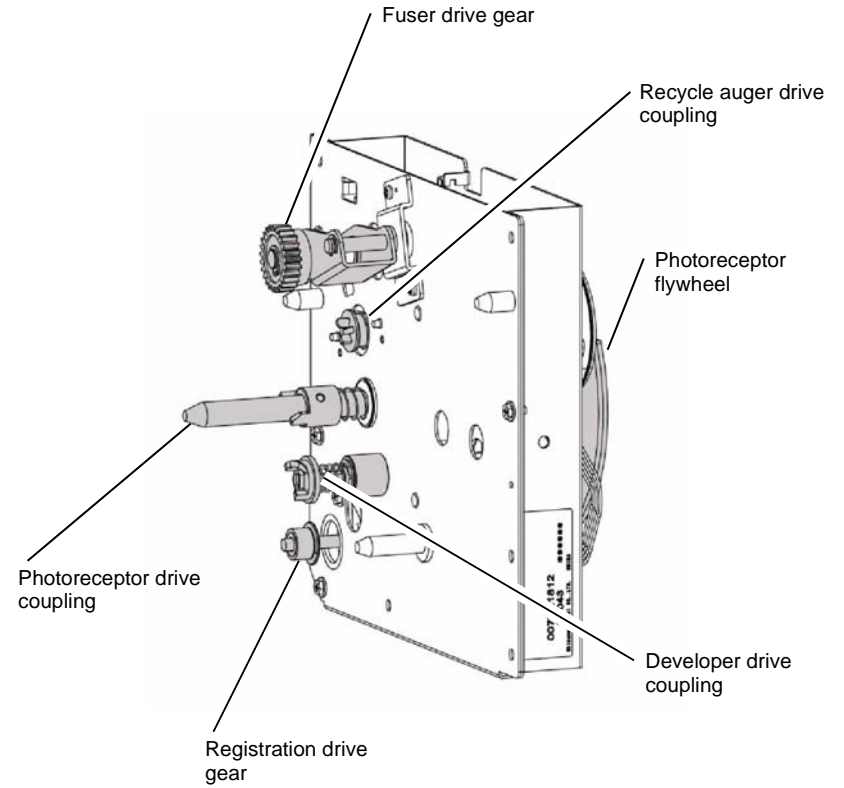
Figure 4 shows the location of the drive gears and couplings driven by the main drive motors.

Figure 4 Main drive components
