708P91368
September 2017

Xerox® AltaLink® B8090 Family Multifunction Printer Service Manual

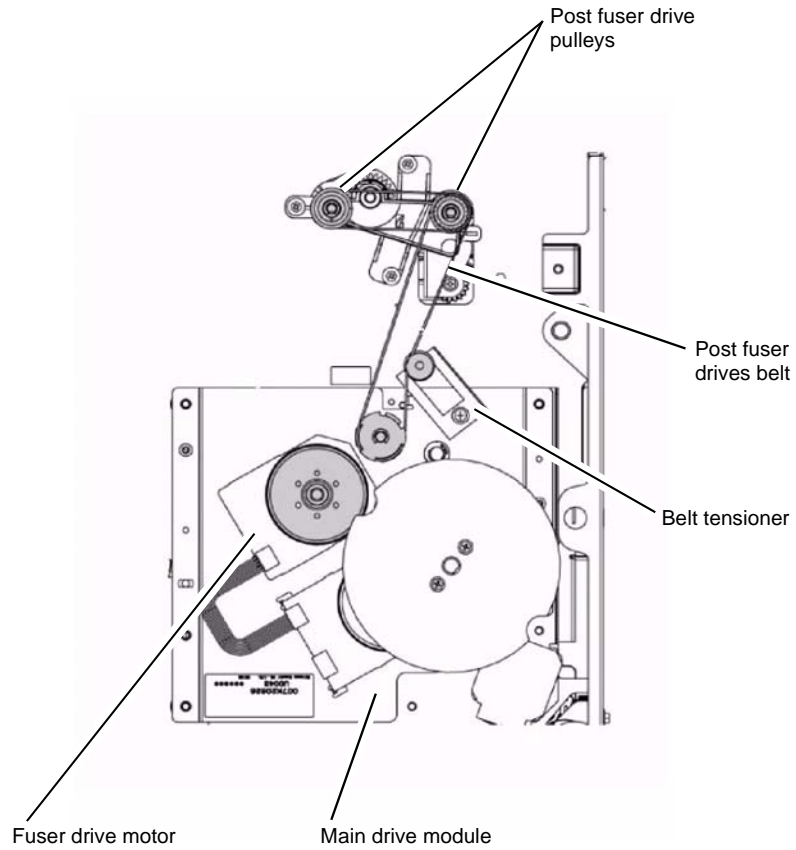
Figure 5 shows the post fuser paper path drive.

Figure 5 Post fuser paper path drive components

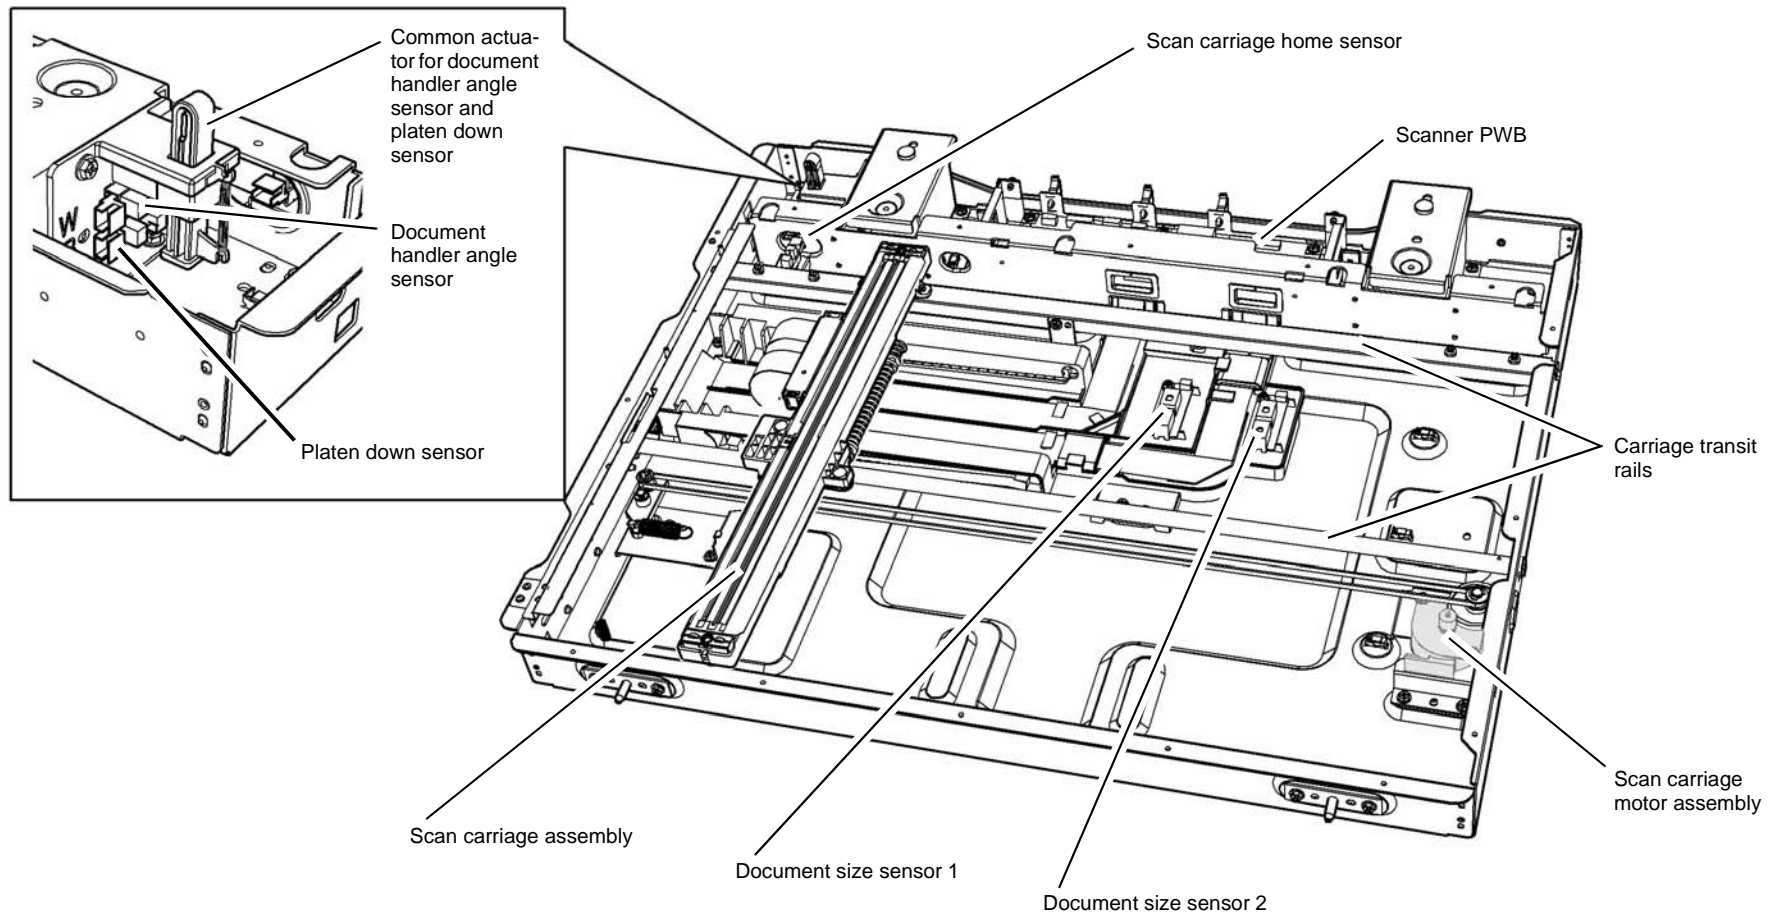
To the front of the scanner enclosure are the scan carriage assembly, scan carriage motor assembly, scan carriage drive belt and pulley system, document size sensors 1 and 2, and the scan carriage transit rails. [Figure 1](#).

To the rear of the scanner enclosure, between the hinges, is the the electronics enclosure tray which houses the scanner PWB within electromagnetic emissions (EME) shielding. To the left of the electronics enclosure are the scan carriage home sensor, document handler angle sensor and platen down sensor.

Figure 1 Scanner module

The scan carriage assembly slides on front and rear rails. Drive to the scan carriage assembly is provided by the scan carriage drive belt. The drive belt is driven by the scan carriage motor assembly on the right side of the scanner cavity. The scan carriage is clamped to the drive belt, so that rotation of the scan carriage motor causes the scan carriage assembly to translate to the left or right. The scan motor power and control comes from the scanner PWB located in the electronics enclosure of the scanner module. [Figure 1](#).

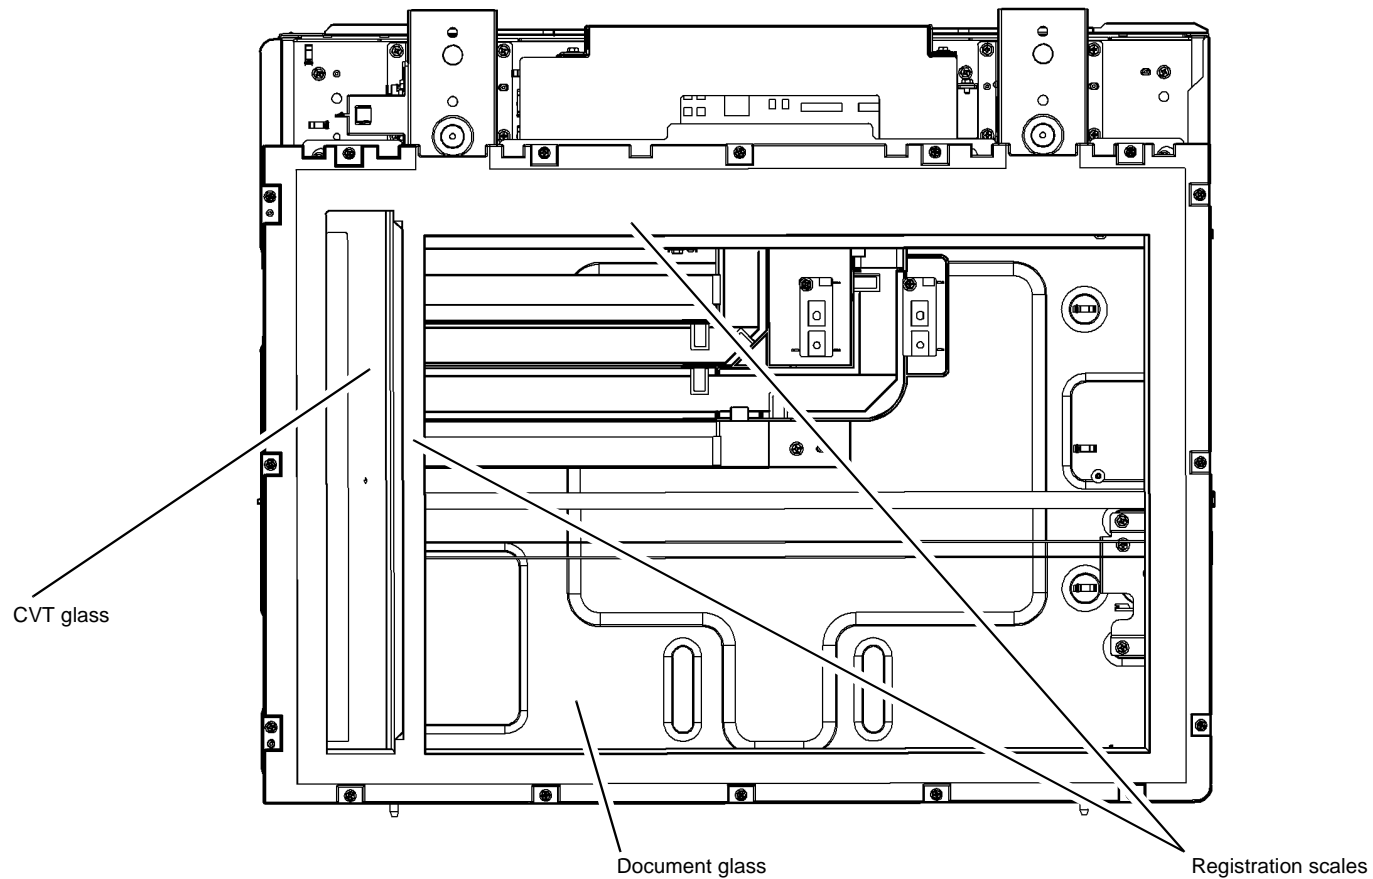
A white calibration strip is located on the under side of the top cover assembly, between the CVT and the document glass. This white strip stretches from the front to the back of the top cover assembly, providing a scannable area for the full width of the scan carriage assembly, [Figure 2](#).

The calibration strip provides a uniform reference for the video control system, which uses it to calibrate the video data. Calibration is necessary because tolerance variations in the scanner may result in different video data. The calibration procedure scans the calibration strip, compares the signals to set point values stored as Non-Volatile Memory (NVM) data, and then calculates a white point value to ensure consistent video data. There is no black calibration strip. Black calibration is performed with the lamp off.

Figure 2 Document platen

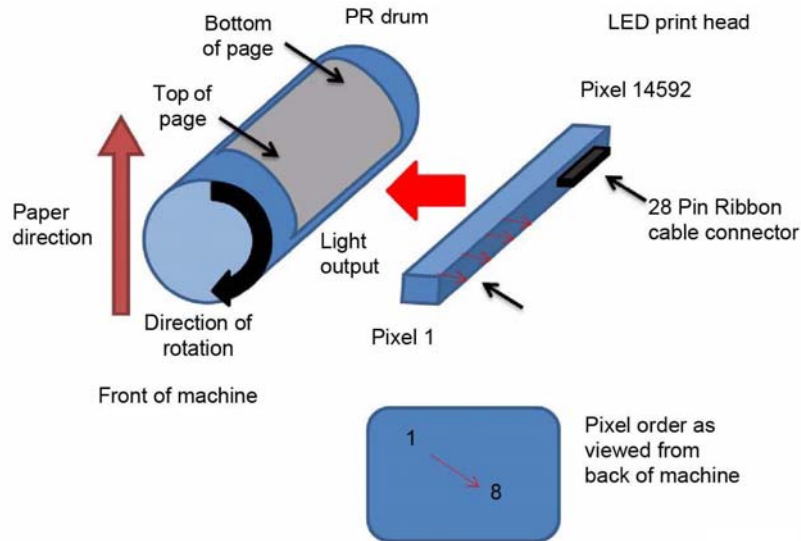
The LED print head consists of 38 chips each with 48 8-LED arrays (14592 LEDs in total), and a focused rod lens array (SLA20DG). The print head writes latent image in a straight line to the photoreceptor drum.

Light power variation compensation is applied for every dot and every chip by LED-drive current-control-circuit with built-in driver IC. This compensation value for each dot and each chip is stored in built-in EEPROM (128kb) which is pre-loaded in manufacturing with the compensation data for the LED print head. This data is extracted from the EPROM and loaded into the LED drivers on initialization of the print head at power up. The print head has a built-in temperature sensor IC. LED drive current can be regulated and light power changed to compensate for temperature variations.

Figure 1 LED print head and drum

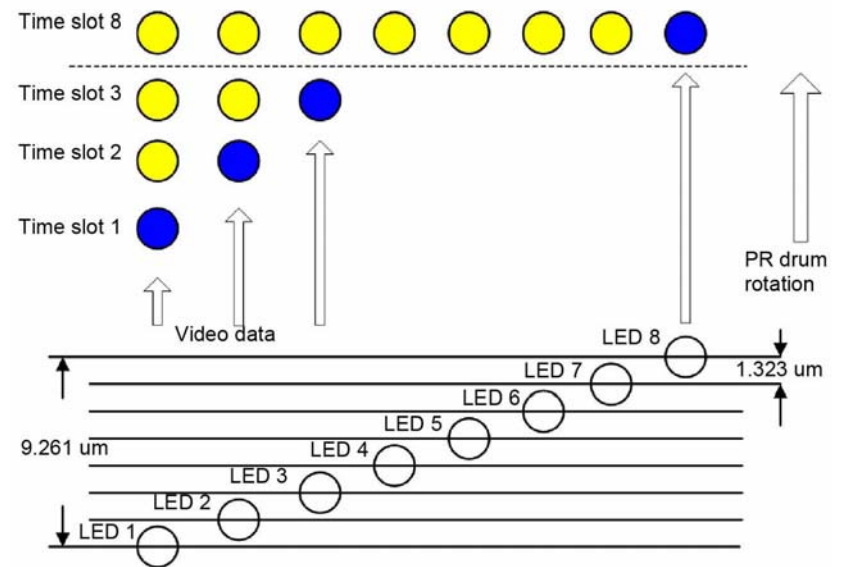
The LED's are arranged in (19+19) chips with 48 elements, each with an 8 LED array. This angled arrangement results in a high resolution LED print head

The LED print head data is sent sequentially for each of the 8 rows of LEDs. The timing of the data to each row is set such that the LEDs form a continuous line when written on the photoreceptor as illustrated in [Figure 2](#). As the drum rotates each LED line is written, eventually forming a continuous line on the drum.

Figure 2 Writing video data on the drum

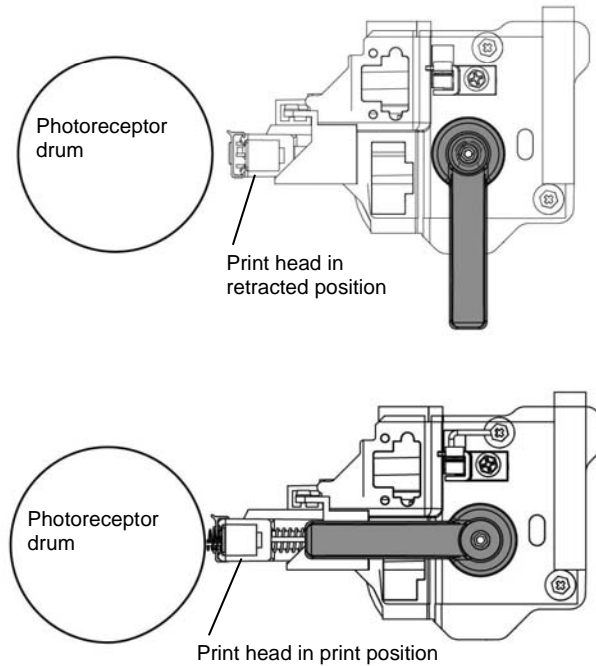
The LED print head has a short focal length and is located close to the photoreceptor drum. To maintain the correct distance from the photoreceptor drum, the print head rests on 2 datum pins that are on the print cartridge.

Refer to [Figure 3](#). The LED print head must be cammed off and moved away from the photoreceptor drum before removing the print cartridge CRU. It is important that the LED print head is correctly positioned (cammed in) for normal operation. This should be confirmed to ensure correct imaging on the photoreceptor Drum.

Figure 3 LPH positioning (1 of 2)

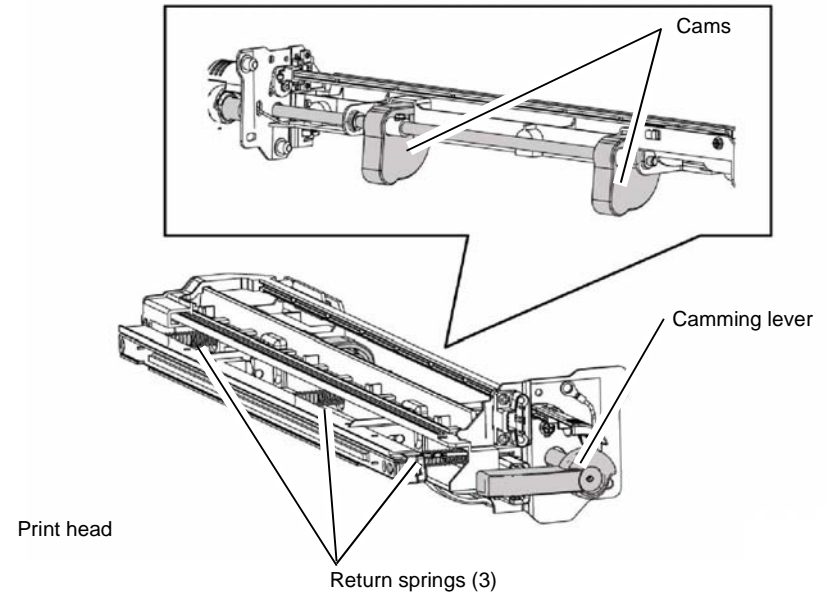
Figure 4 LPH positioning (2 of 2)

Refer to [Figure 4](#). The LPH is retracted from the photoreceptor drum by rotating the camming lever clockwise.

When the lever is rotated, the cams rotate and allow the return springs to move the print head away from the surface of the drum.

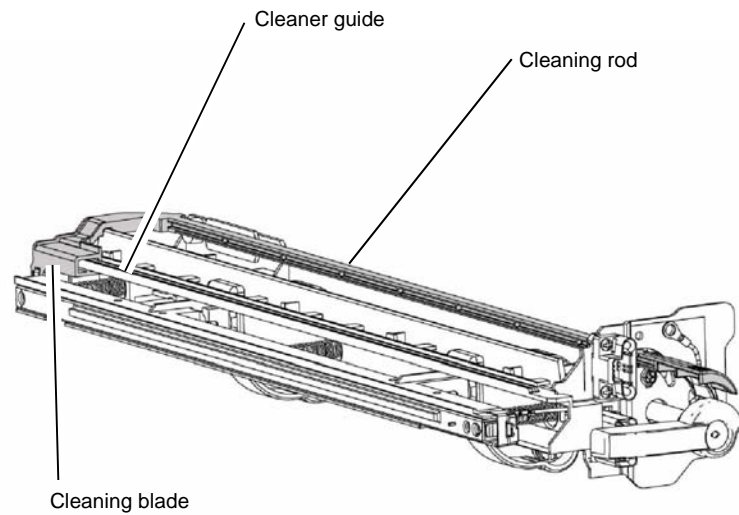
Figure 5 LPH manual cleaner

The manual cleaner must only be operated with the LED print head cammed away from the photoreceptor drum. It must be returned to its fully home position before the LED print head is cammed into the print position.

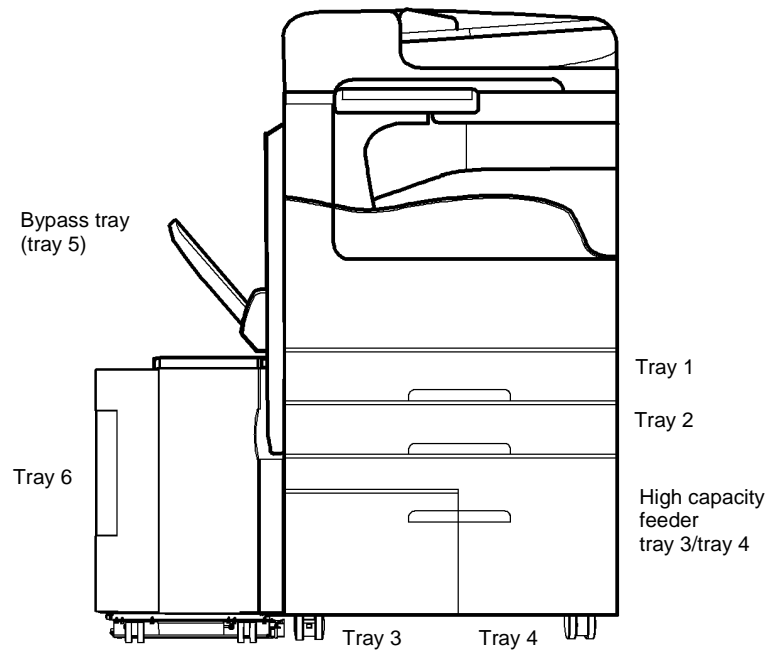
Figure 1 Paper trays

Figure 1 shows the position of the paper trays with the optional tray 3/tray 4 (HCF) and tray 6 (PFP).

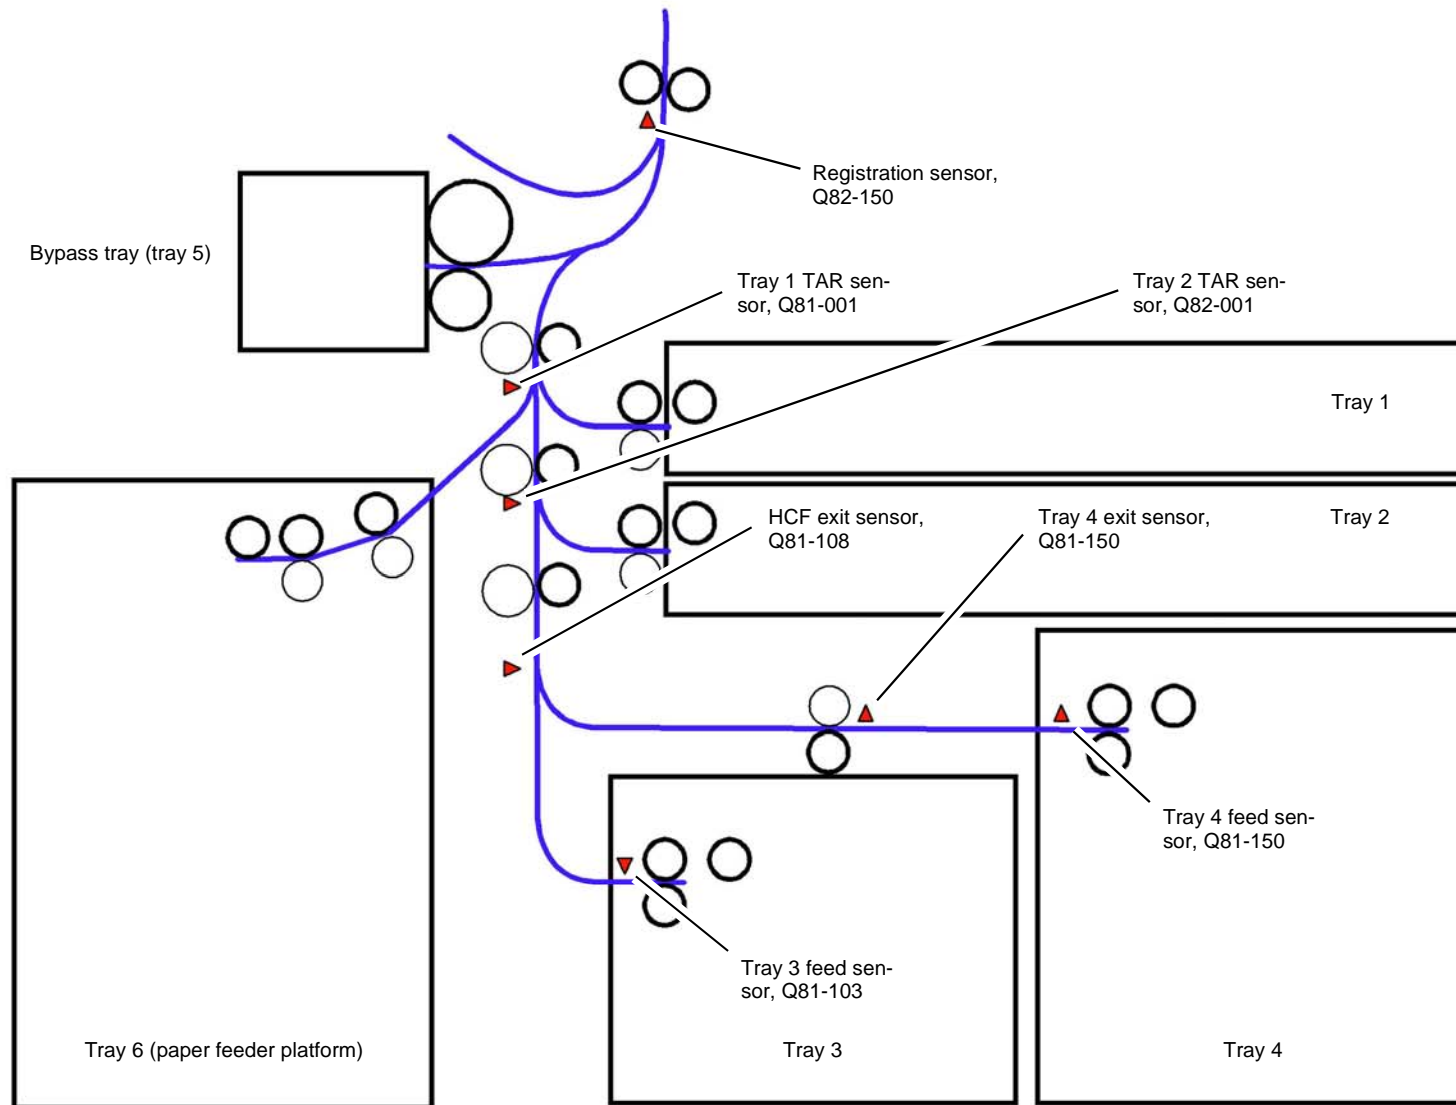
Figure 3 Paper feed sensors

Figure 3 shows the location of the paper feed sensors.

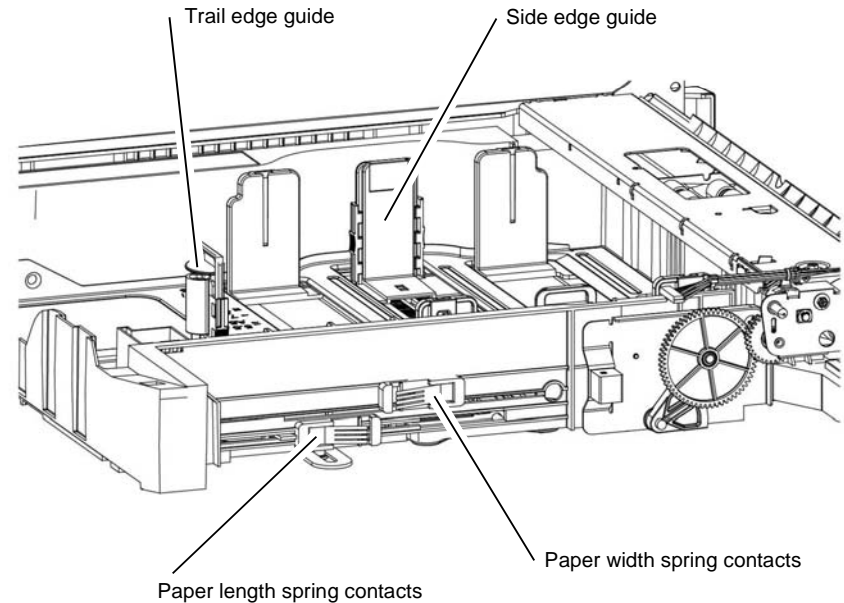
Figure 5 Tray 1 and tray 2 sensing components

The paper size sensing PWB for paper tray 1 and paper tray 2 is shown in [Figure 5](#) and [Figure 6](#).

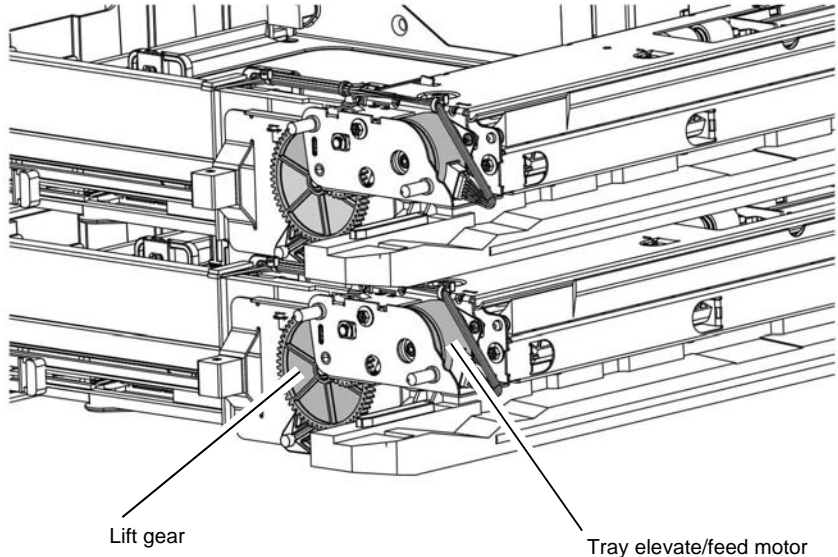
Figure 7 Tray elevate/feed motors

Paper trays 1 and 2 each have an elevate system which lifts the paper stack. In order to position the paper stack at the feed position the elevate plate, which is hinged to the rear of the paper tray, is raised by a lift bar. Elevation of the paper tray is achieved by driving the tray feed motor in the reverse direction through a gear train and a one-way clutch. [Figure 7](#).

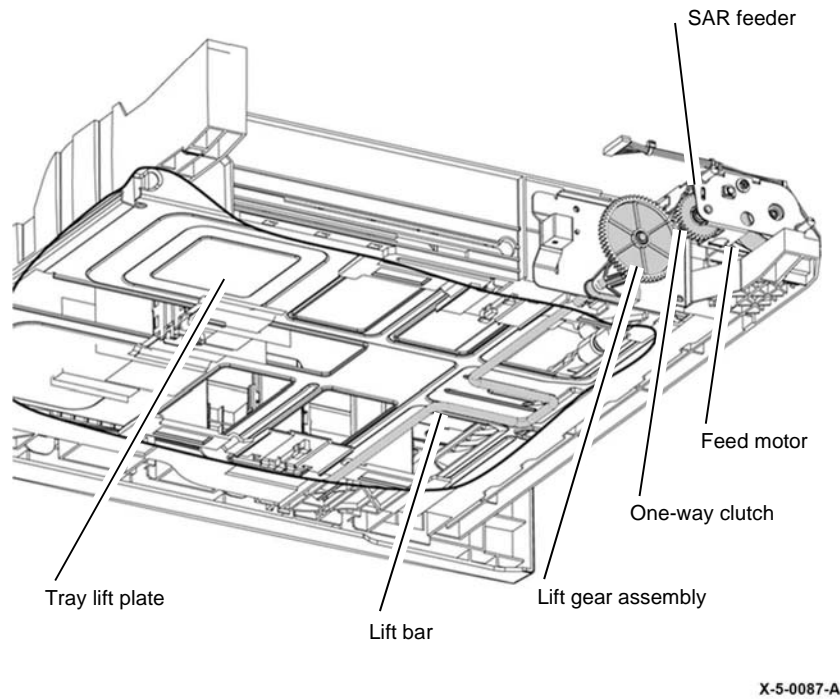
Figure 8 Tray 1 and tray 2 elevate system

The nudger roll is turned by a small belt drive from the feeder roll shaft, which is driven by the elevate/feed motor. When the top sheet is fed to the feed roll, a single sheet has sufficient friction to turn the retard roll, and continue being fed. If two sheets are fed, there will not be enough friction between the two sheet to drive the retard roll, and therefore the lower of the two sheets is stalled in the nip and is not fed through the feed nip.

The fed sheet is then detected by the TAR sensor located within the left door assembly as it is passed to the registration area of the IOT. The sheet from tray 1 is passed via transport roll 1 with its associated TAR sensor. The sheet from tray 2 is passed via transport roll 2 with its associated TAR sensor.

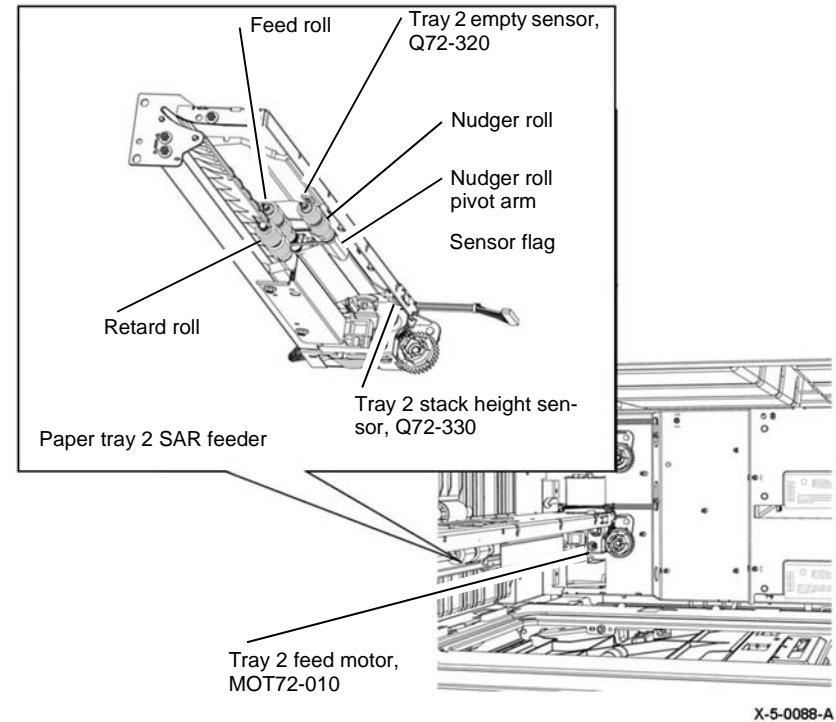
Figure 9 Tray 1 and tray 2 feed components

Trays 1 and 2 have identical semi active paper feeders. Figure 9 shows the paper feeder component location. When the tray is closed the following occurs:

1. The tray elevate/feed motor energizes, rotating the lift gear that drives the lift bar. The lift bar then raises the paper lift plate.
2. The nudger assembly lowers.
3. As the tray is raised, the stack of paper contacts the nudger roll.
4. The tray continues to raise until the flag on the nudger assembly actuates the stack height sensor.
5. When the stack height sensor changes state, the tray elevate / feed motor is de-energized.

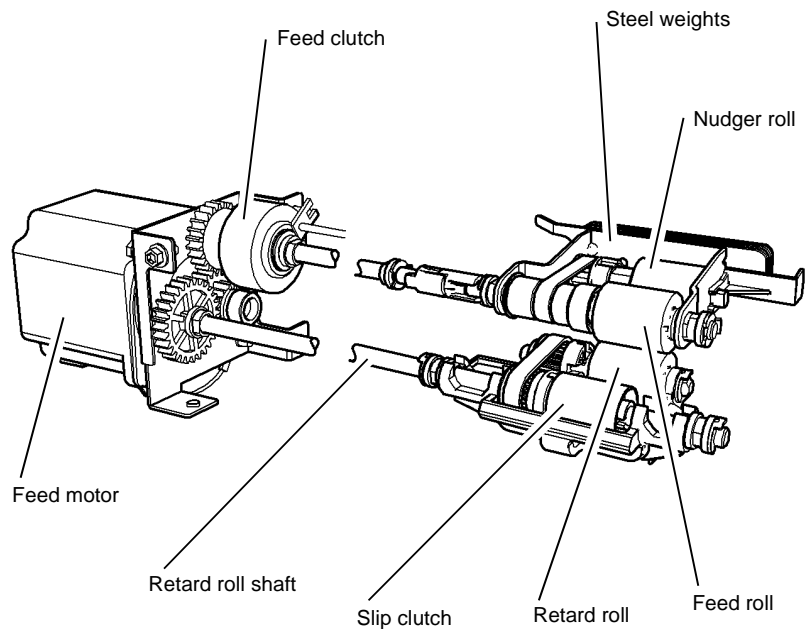
Figure 10 Fully active retard feeder mechanism

The feed roll and nudger roll are driven from the feed motor via an electromagnetic feed clutch. When the feed clutch is engaged the feed roll and nudger roll are driven in the forward direction.

When paper feed is initiated the feed motor and feed clutch are energized. The feed roll and nudger roll are driven in the forward direction. The nudger roll rests on top of the paper stack, the top sheet is driven into the feed nip as the nudger rotates. The retard roll turns in forward direction due to the drive force from the feed roll (the slip clutch slips).

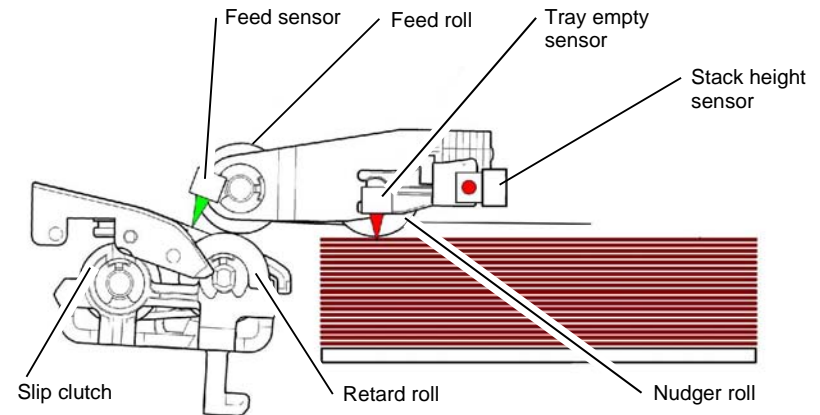
Figure 11 Feed sequence step 1

Feed motor off, feed clutch off. Just prior to paper feed, the nudger roll, feed roll, and retard roll are stationary.

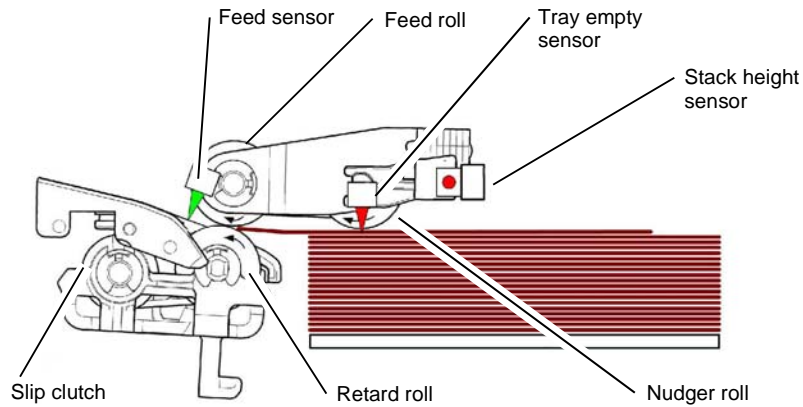
Figure 12 Feed sequence step 2

Feed motor on, feed clutch on, feeding the top sheet from the stack. The feed roll drives the retard roll and the slip clutch slips.

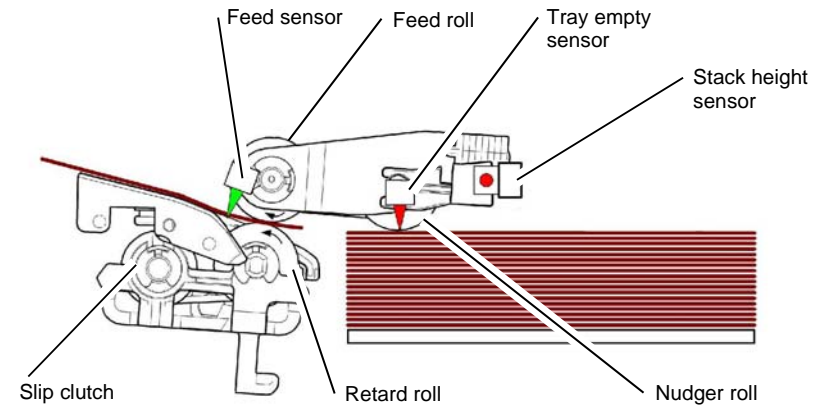
Figure 14 Feed sequence step 5

Feed motor on, feed clutch off, the sheet exits the top of the stack. The nudger roll drops to the next sheet. The sheet is pulled by the nip of the takeaway roll. (The takeaway roll is in the paper path in the left door.) The feed roll and retard roll are driven by paper friction.

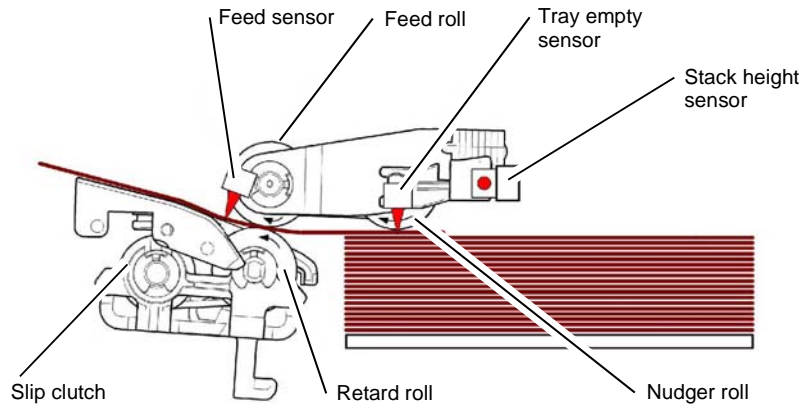
Figure 13 Feed sequence step 4

Feed motor on, feed clutch on, the sheet continues along the paper path. Paper friction drives the retard roll, and the slip clutch slips.

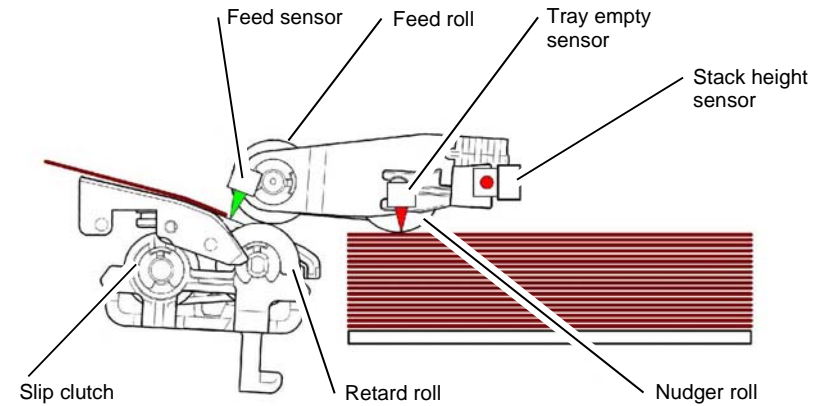
Figure 15 Feed sequence step 6

The trail edge of the sheet is at the feed sensor, the feed motor is off, and the feed clutch is off. The sheet continues along the paper path.

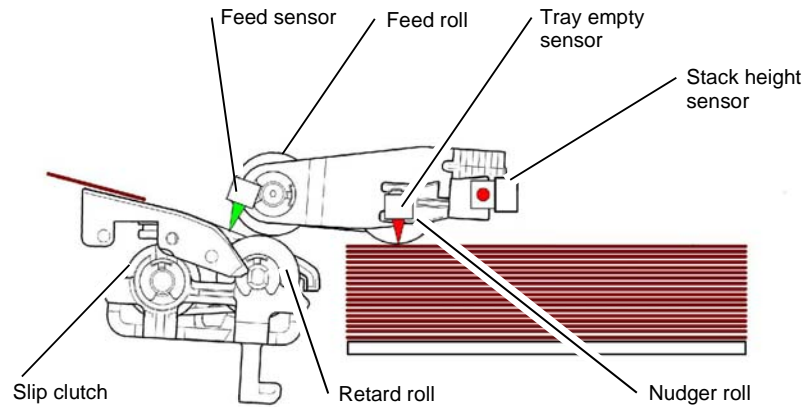
Figure 16 Feed sequence step 7

The sheet continues along the paper path. The feed motor and the feed clutch are off.

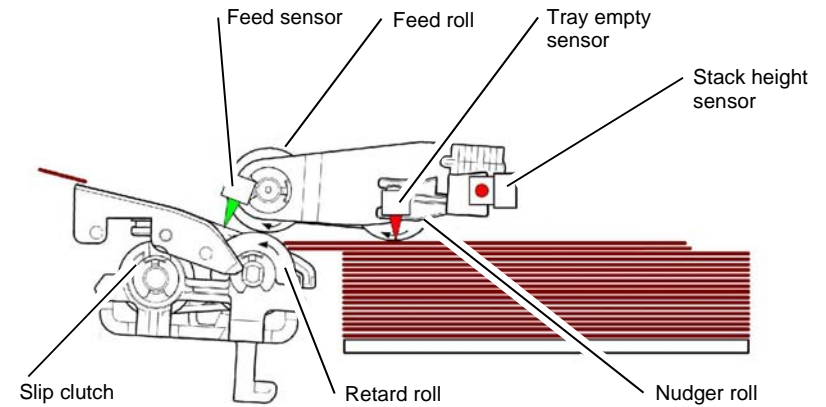
Feed motor on and feed clutch on. The feed roll drives the retard roll and the slip clutch slips. A multi-feed is shown leaving the top of the paper stack.

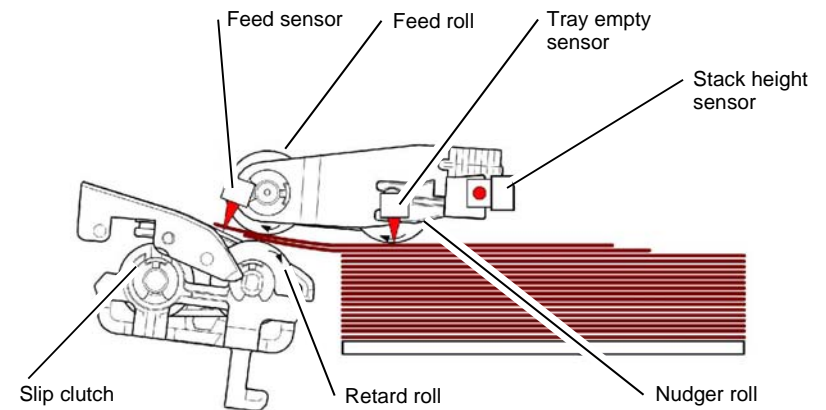
Figure 18 Multi-feed sequence step 2

Feed motor on and feed clutch on. The multi-sheet feed is now in the feed nip. The feed roll grips the top sheet, but since the inter-sheet friction is low, the retard roll now grips the lower sheet and pushes it back toward the paper tray.

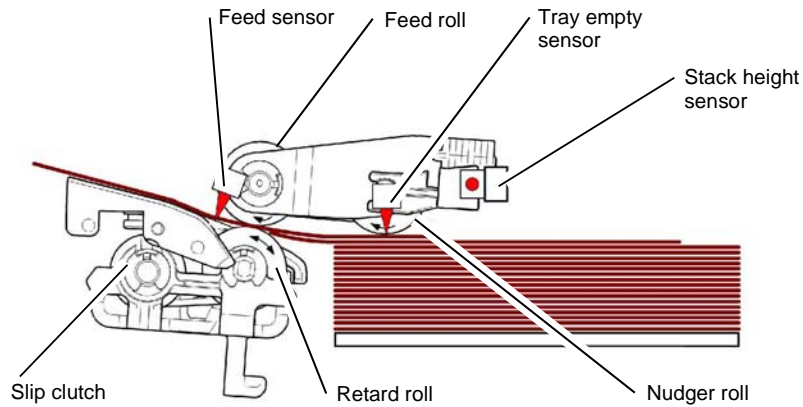
Figure 19 Multi-feed sequence step 3

Feed motor on and feed clutch on. The lower sheet of the multi-feed will be pushed back toward the paper tray. The top sheet continues to be fed by the feed roll.

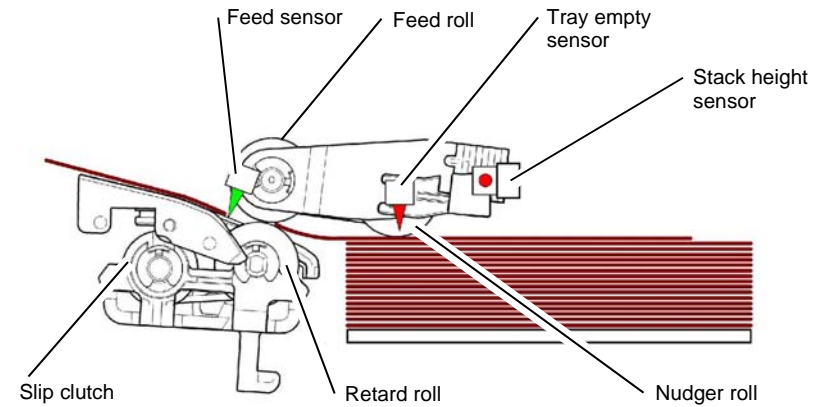
Figure 21 Multi-feed sequence step 5

The trail edge of the sheet is at the feed sensor and the feed motor and the feed clutch are off. The held sheet from the multi-feed is held in the feed nip awaiting the next sheet feed command.

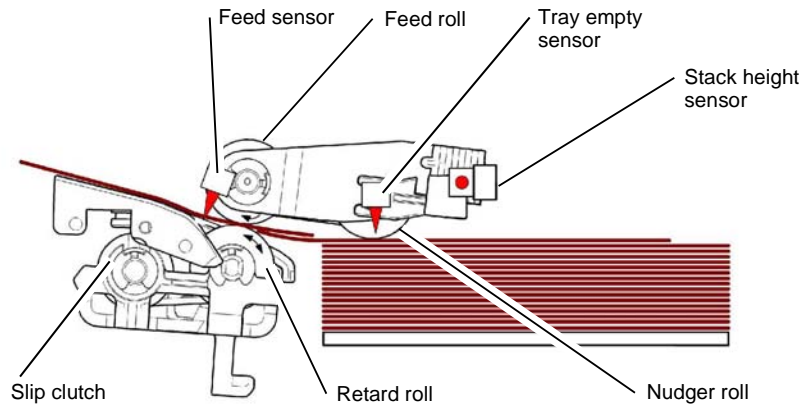
Figure 20 Multi-feed sequence step 4

Feed motor on and feed clutch off. The sheets exit the top of the stack and the nudger roll drops to the next sheet. The lower sheet of the multi-feed will continue to be held by the retard roll. The sheet is pulled by the nip of the takeaway roll. (The takeaway roll is in the paper path in the left door.) The feed roll is driven by paper friction.

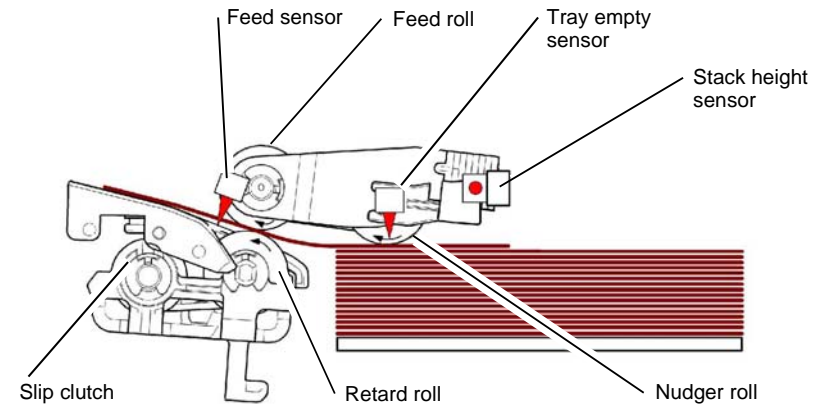
Figure 22 Multi-feed sequence step 6

Feed motor and the feed clutch are on. The held sheet from the multi-feed is now fed out of the tray.

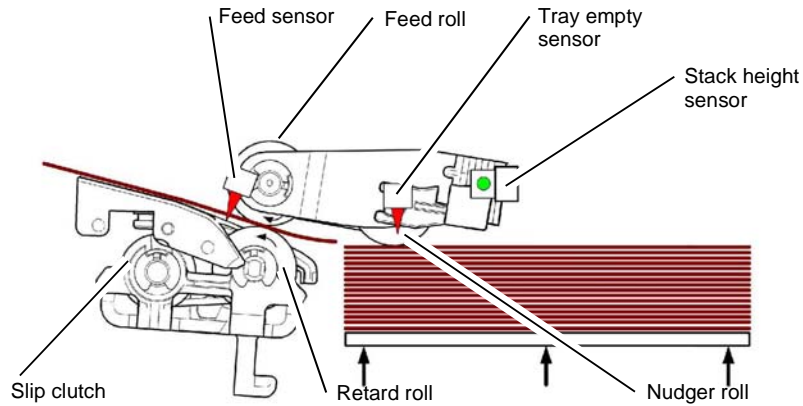
Figure 23 Multi-feed sequence step 7

Feed motor on, feed clutch off, the sheet exits the top of the stack. The nudger roll drops to the next sheet. The sheet is pulled by the nip of the takeaway roll. The feed roll and retard roll are driven by paper friction. The stack height sensor does not detect a flag, so the elevator motor is energized to lift the tray.

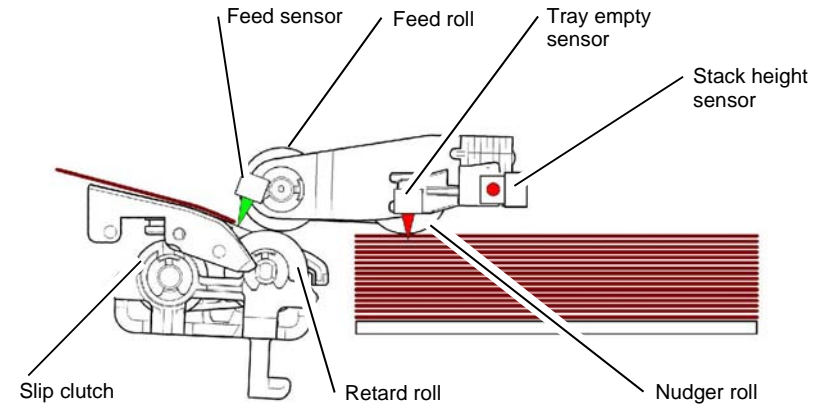
Figure 25 Multi-feed sequence step 9

Feed motor off and feed clutch off. The trail edge of the sheet is at the feed sensor. The tray elevator is stopped.

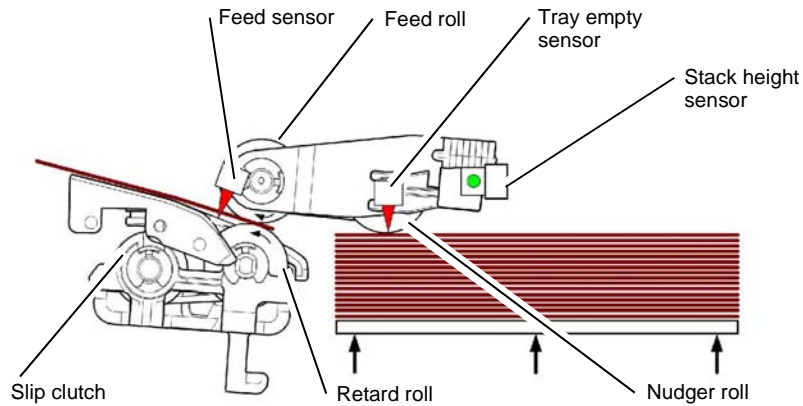
Figure 24 Multi-feed sequence step 8

Feed motor off and feed clutch off. The sheet continues along the paper path. The feed roll and the retard roll are driven by paper friction. The stack height sensor detects the top of the paper stack, causing the tray elevator motor to stop.

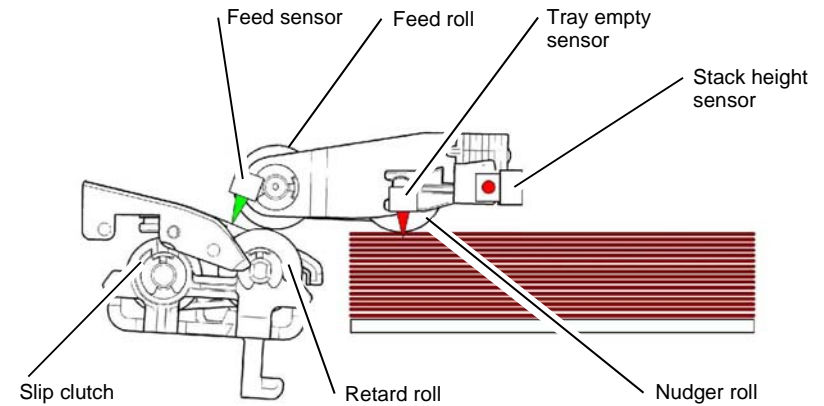
Feed motor off and feed clutch off. The sheet has left the feeder area. The feeder awaits the next feed command.

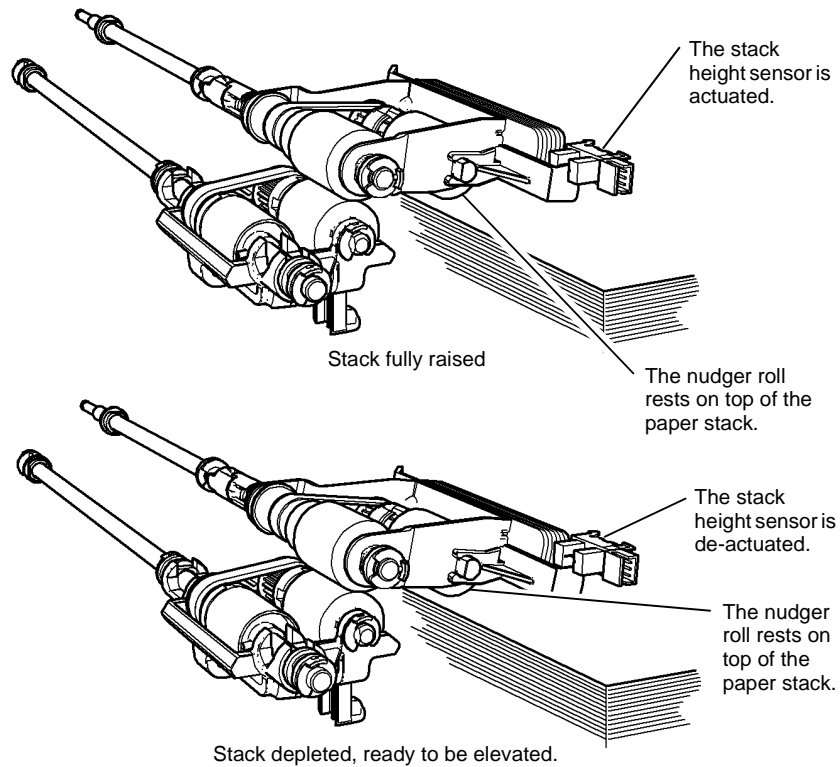
Figure 27 Paper stack height monitoring

Figure 27 shows the mechanism for monitoring the paper stack height.

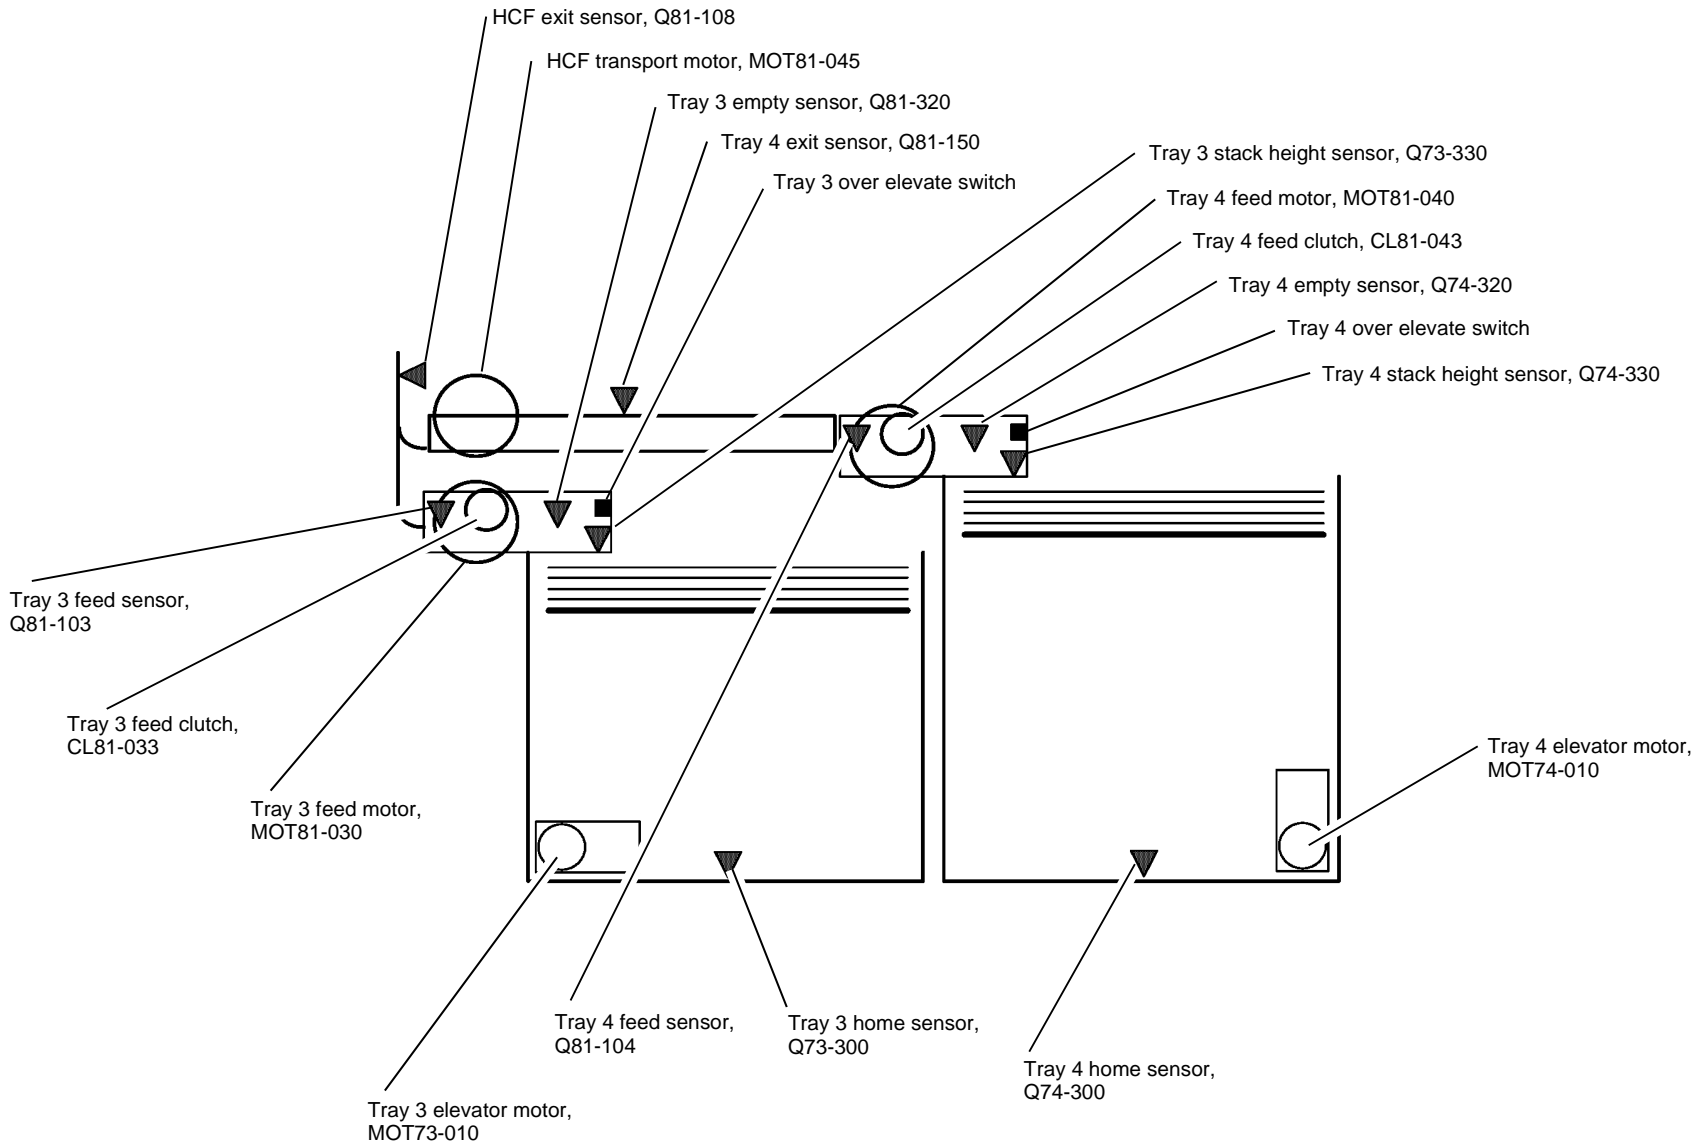
Figure 28 HCF electrical components

Figure 28 shows the electrical components in the HCF.

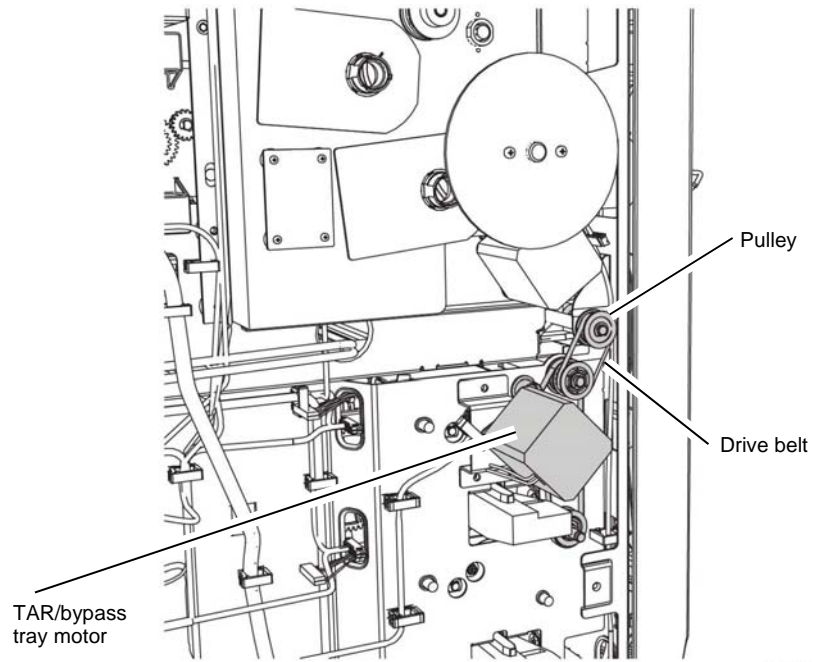
Figure 29 Drive components (IOT side)

Refer to [Figure 29](#), [Figure 30](#) and [Figure 31](#). The bypass tray is on the left-hand side of the IOT with a capacity of approximately 100 sheets of 80gsm paper. Drive for the bypass tray is provided by the TAR/bypass tray motor MOT80-006. Drive for the bypass tray drive gears is provided by a belt that is driven by a pulley on the tray 1 transport roll shaft. The feed clutch, when energized, transfers drive from the bypass tray drive gear to the shaft of the feed roll.

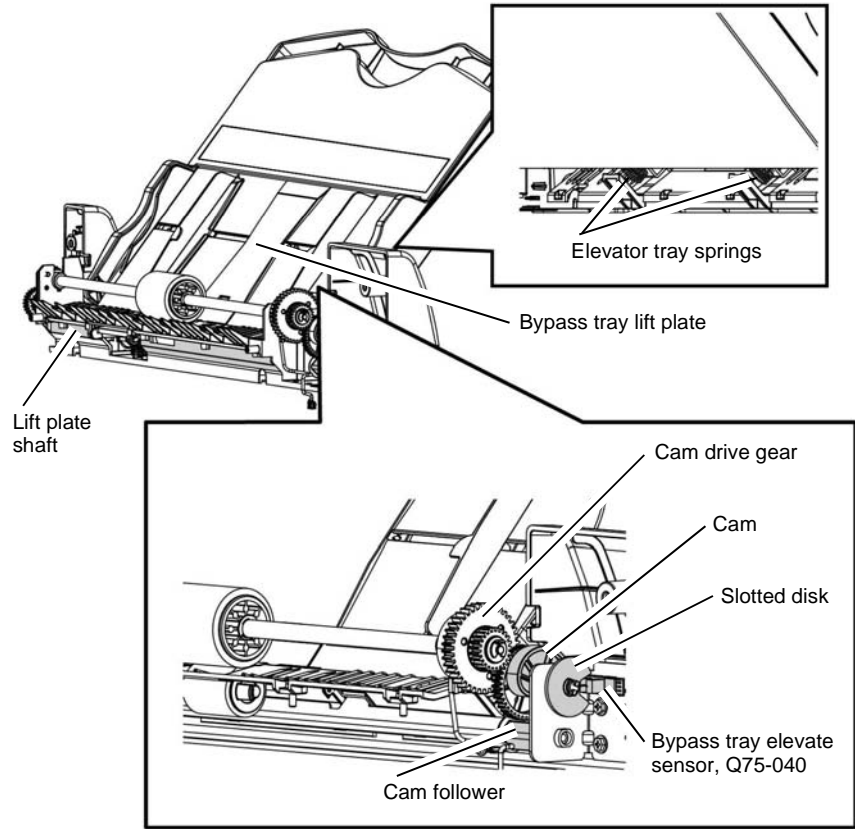
Figure 30 Elevate components

The bypass tray is mounted to the left door assembly and consists of the following:

- Cam
- Cam follower
- Slotted disk
- Lift plate shaft
- Bypass tray lift plate
- Elevator tray spring (2)
- Bypass tray elevate sensor, Q75-040
- Bypass tray clutch, CL75-325 (powered by a non interlocked 24V supply)
- Feed roll
- Retard roll
- Feed roll drive gear
