708P91368
September 2017

Xerox® AltaLink® B8090 Family Multifunction Printer Service Manual

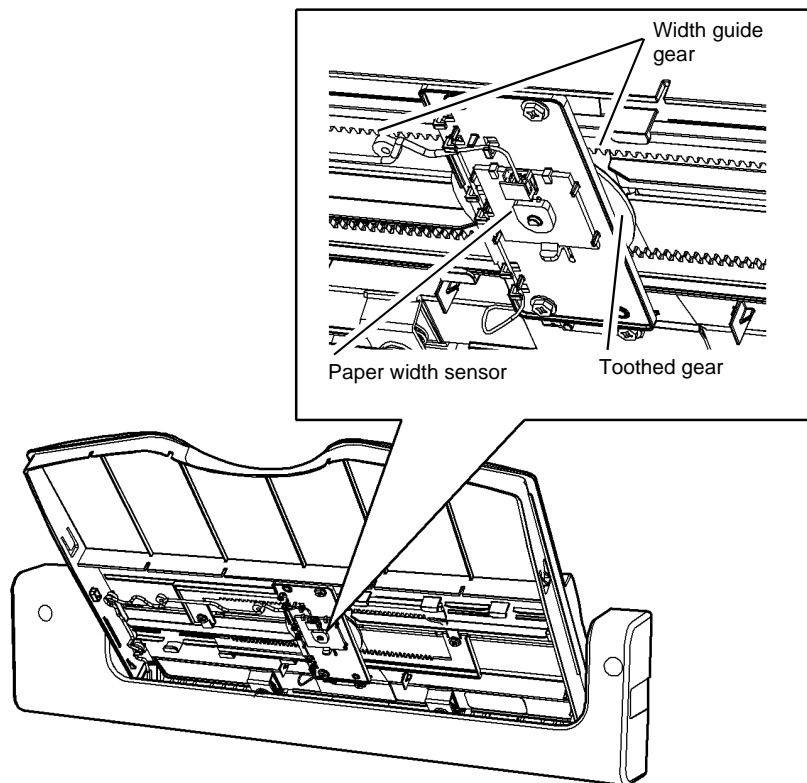
Figure 32 Bypass tray paper width sensing

Both the front paper side guide and the rear paper side guide are connected to a gear rack on the underside of the tray. As the paper side guides are moved, both gear racks rotate a toothed gear. This gear is mounted on a D-shaft. When the shaft rotates, it rotates the paper width sensor potentiometer. The voltage sensed is used by the control logic to determine paper width. Refer to [Figure 32](#).

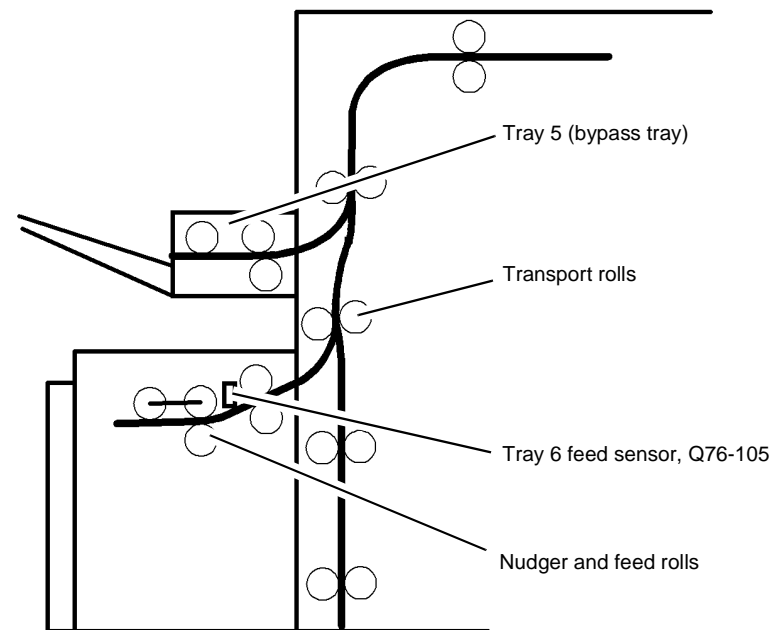
Figure 33 Paper path

[Figure 33](#) shows the paper path between tray 6 and the machine.

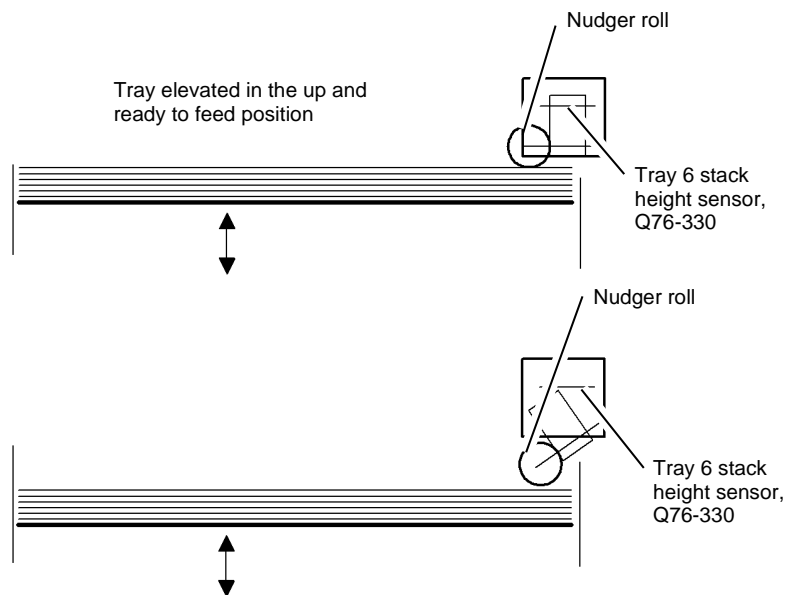
Figure 34 SAR feeders

This consists of a nudger roll, mounted on a pivoting arm, as shown in Figure 34.

NOTE: Retard roll and other parts of SAR assembly not shown.

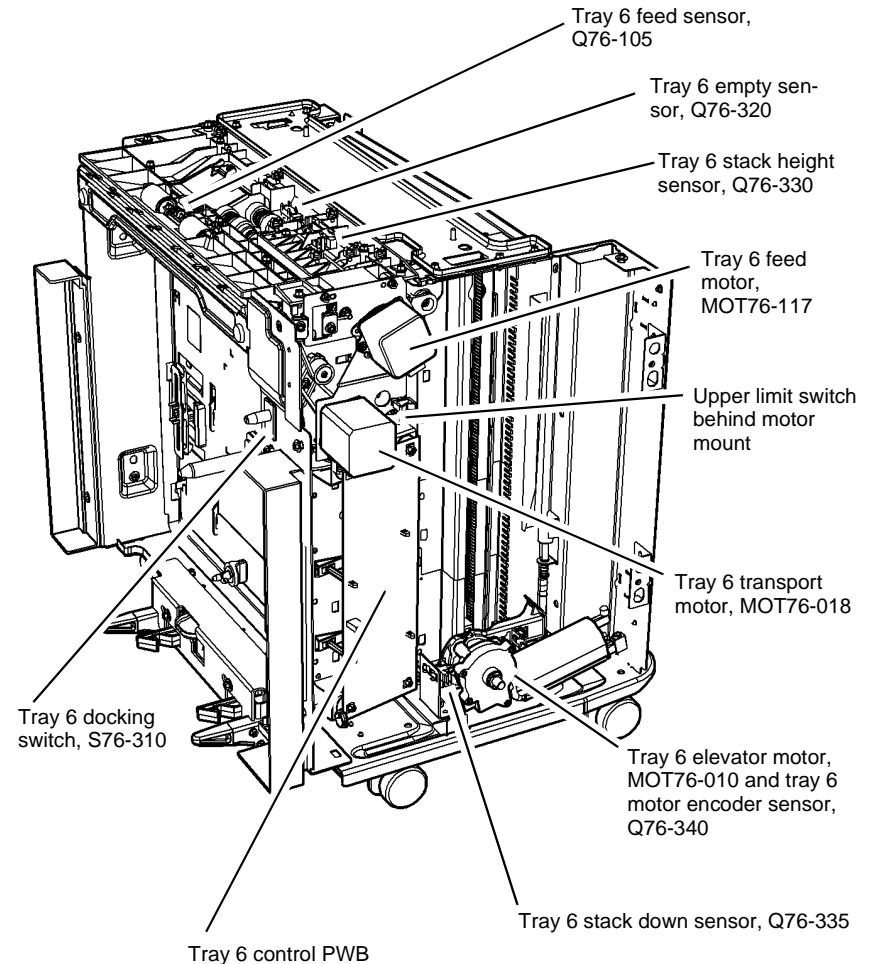
Figure 35 Component location

Refer to Figure 35 for the location of components, motors and sensors.

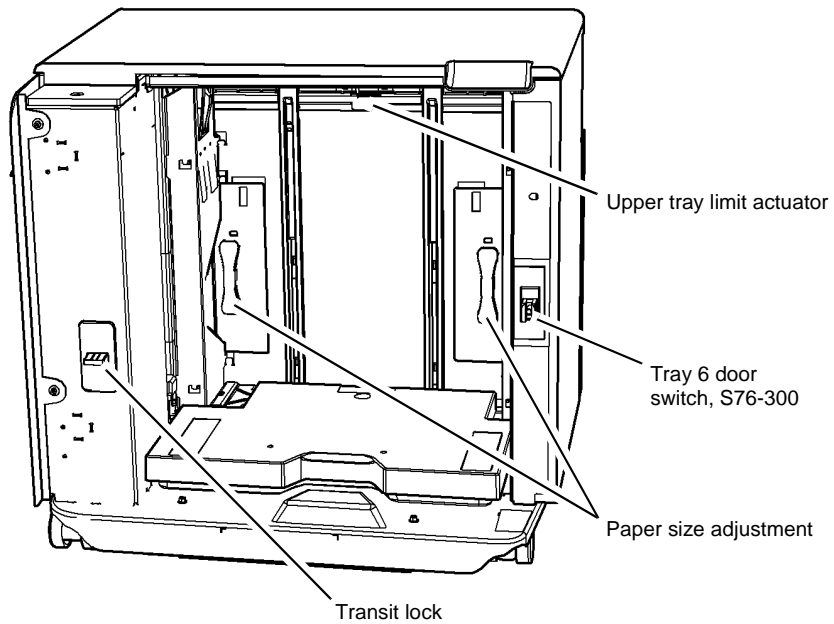
Figure 36 Component location

Refer to [Figure 36](#) for the location of the transit lock, paper size adjustment, door switch and upper limit switch.

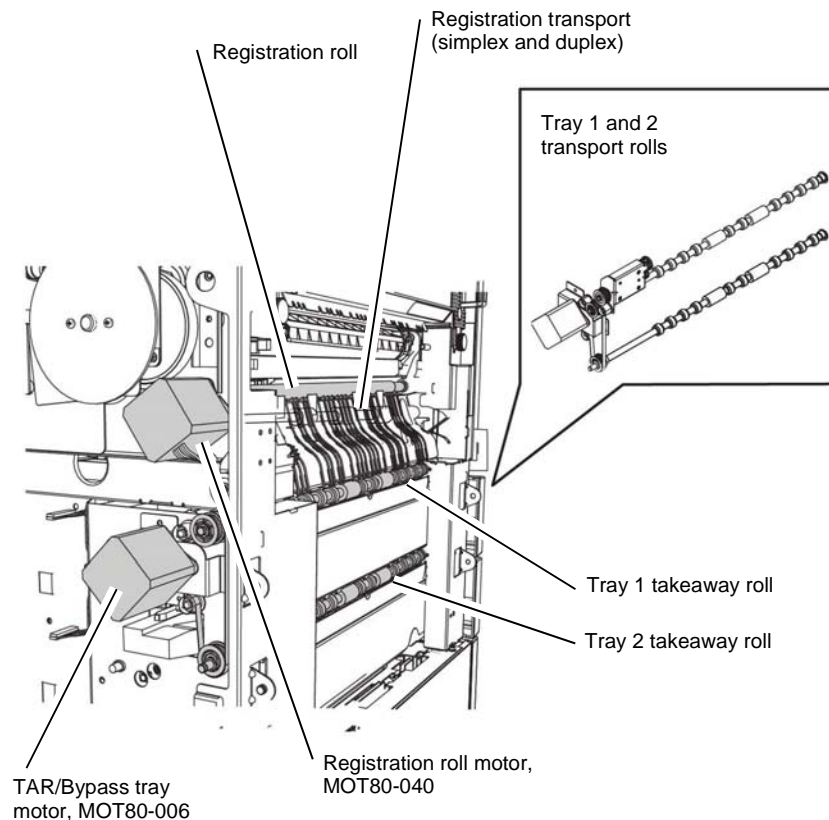
Figure 1 Paper transport components

Component Name	Description
TAR/Bypass tray motor	In the forward direction, this motor drives the transport rolls for tray 1 and tray 2. In the reverse direction, this motor provides drive for the feed roll in the bypass tray.
Registration motor, MOT80-040 (part of the main drive module)	This motor provides drive for the registration rolls via the registration roll drive belt and the registration drive pulley on the registration roll. The registration rolls move the paper from the registration transport to the xerographic subsystem where the image is transferred to the paper. The registration idler rolls are located in the left door assembly.
Registration sensor, Q82-150	Detects the paper just prior to the registration transport.
Tray 1 TAR sensor Q81-001 PL 80.10 Item 5	As the paper is transported from trays 1-4, this sensor detects the paper as it exits the tray 1 TAR nip.
Tray 2 TAR sensor, Q82-001 PL 80.10 Item 5	As the paper is transported from trays 2-4, this sensor detects the paper as it exits the tray 1 TAR nip.

HCF transport motor, MOT81-045	This motor drives the HCF transport roll and also the transport roll in a 2 tray HCF configuration.
HCF exit sensor, Q81-108	Detects the paper as it leaves the HCF. The paper is exiting tray 3 or the tray 4 transport.
Duplex motor, MOT83-060 (45 & 55 ppm variants) PL 80.22 Item 8	This motor provides drive for the upper, mid and lower duplex rolls. It takes the copies that have been inverted and delivers them to the registration area.
Duplex motor, MOT83-062 (65, 75 and 90 PPM variants) PL 80.22 Item 8	This motor provides drive for the upper, mid and lower duplex rolls. It takes the copies that have been inverted and delivers them to the registration area.

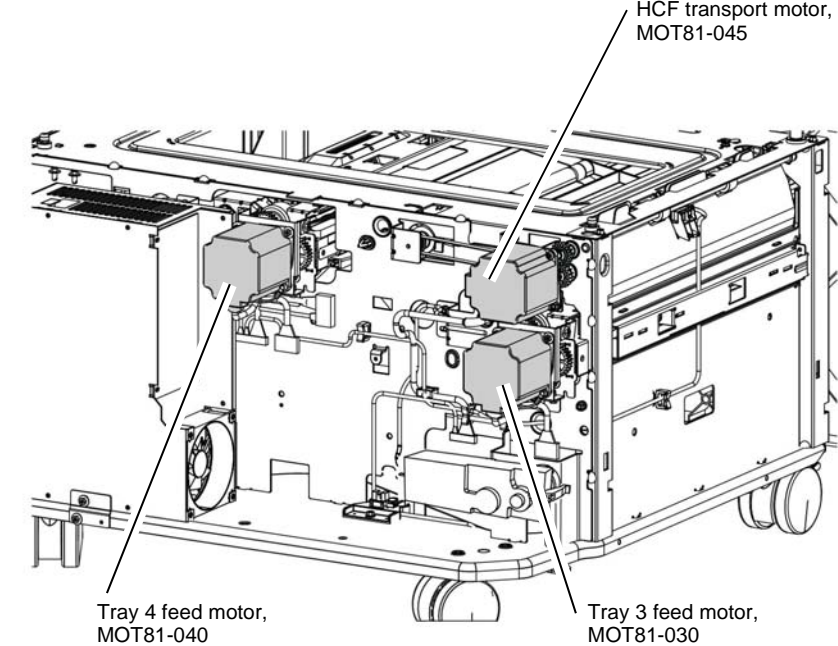
X-5-0114-A

Figure 2 Paper registration components

Refer to [Figure 1](#), [Figure 2](#), [Figure 3](#) and [Figure 4](#). When the tray 2 feed motor, MOT81-020 is run in the forward direction to feed a sheet from tray 2, the TAR/bypass tray motor, MOT80-006 is run to drive the transport roll nip. The TAR/bypass tray motor transports the sheet until the lead edge is at the Simplex Stage Location (SSL). The motor speed varies dependent on image to sheet scheduling. If necessary, the sheet will be paused at the SSL to maintain the inter document gap.

Once the sheet has been released from the SSL and the lead edge actuates the registration sensor, Q82-150, the TAR/bypass tray motor accelerates the sheet to process speed. The sheet is driven by the TAR/bypass tray motor to the registration rolls and stops. A buckle is formed in the sheet at the registration rolls to remove skew. At this point there is a small delay for sheet scheduling. After this time has expired, the TAR/bypass tray motor and the registration motor, MOT80-040 are run to transport the sheet to the transfer area.

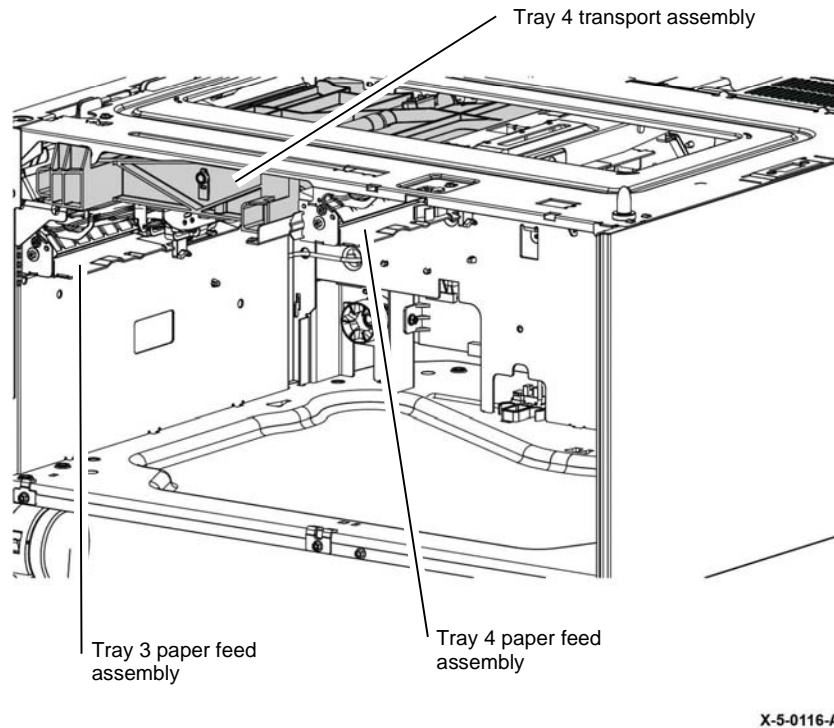
Figure 4 Tray 4 transport assembly

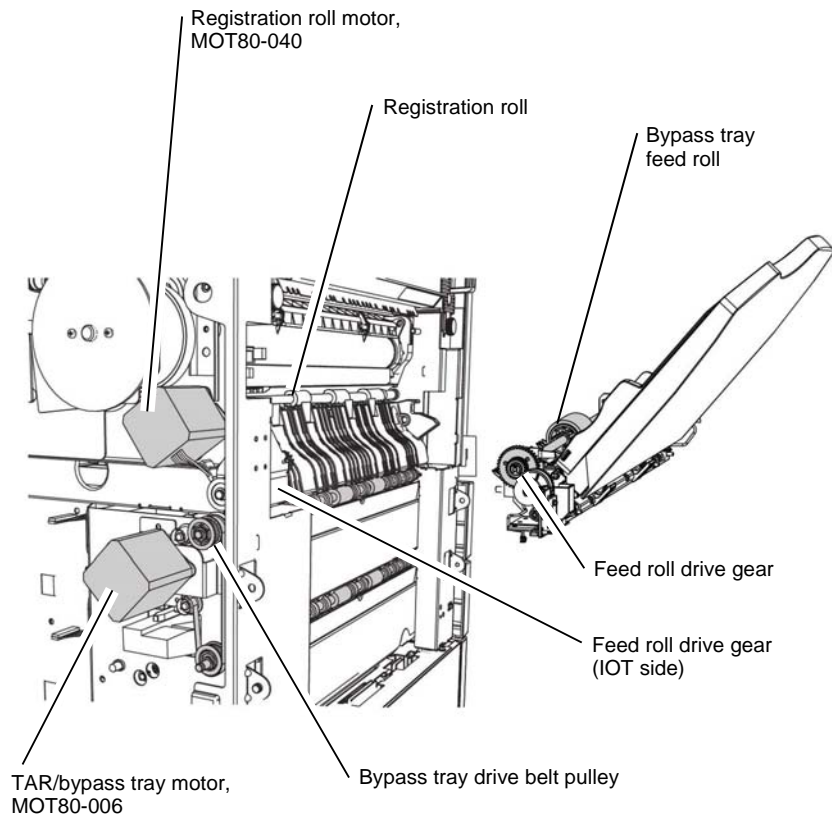
X-5-0117-A

Refer to [Figure 5](#). When the TAR/bypass tray motor, MOT80-006 is run in the reverse direction, it provides drive for the bypass tray feed roll, and for the elevate function in the bypass tray via a cam and cam follower. The TAR/bypass tray motor, MOT80-006 transports the sheet to the registration transport.

Once the lead edge actuates the registration sensor, Q82-150, the TAR/bypass tray motor MOT80-006, accelerates the sheet to process speed. The sheet is driven by the motor to the registration rolls and then stops. A buckle is formed in the sheet at the registration rolls to remove skew. At this point there is a pause for sheet scheduling. After this time has expired, the TAR/bypass tray motor, MOT80-006 (in reverse) and the registration motor, MOT80-040 are run to transport the sheet to the transfer area.

Figure 5 Bypass tray paper feed and registration

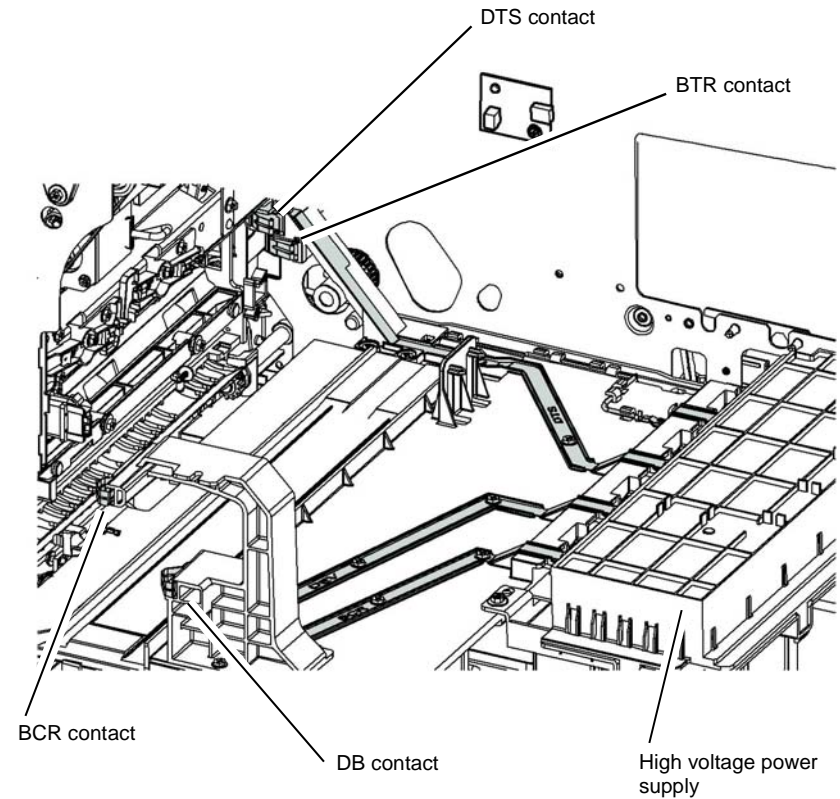
X-5-0123-A

Refer to [Figure 1](#). The xerographics system is supplied the following from the high voltage power supply:

- Bias charge roll (BCR) voltage: - 755V and an AC signal. AC Frequency = 1.6KHz, AC current = 2.0u amps
- Developer bias (DB) voltage: - 600V and an AC signal. AC Frequency 9KHz, AC Voltage 1000V AC.
- Bias transfer roll (BTR) voltage: Controlled by changing the current (Constant current mode)
- Detack saw (DTS) voltage: -2500V

Figure 1 High voltage power distribution

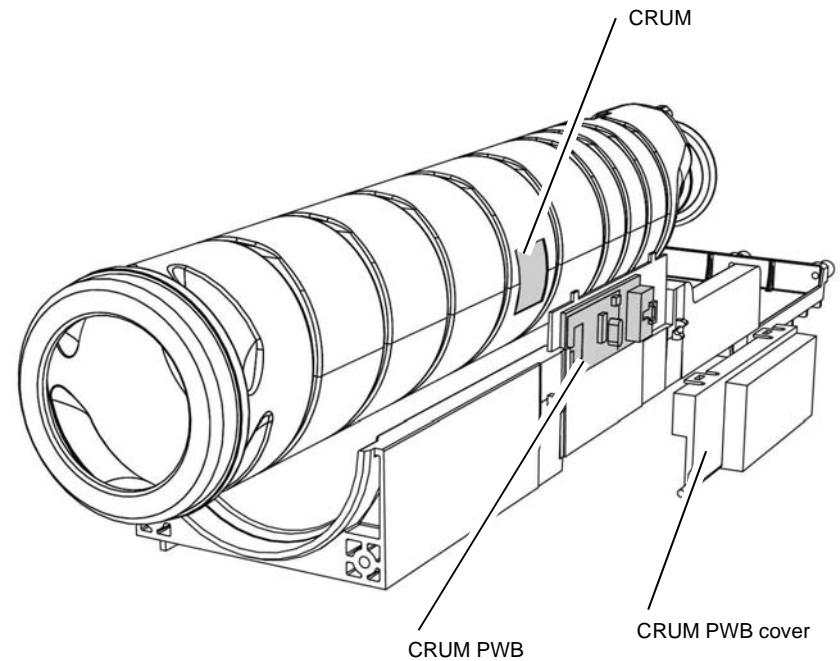
X-5-0124-A

[Figure 2](#) shows the location of the toner cartridge CRUM and the CRUM PWB.

Figure 2 Toner cartridge and CRUM

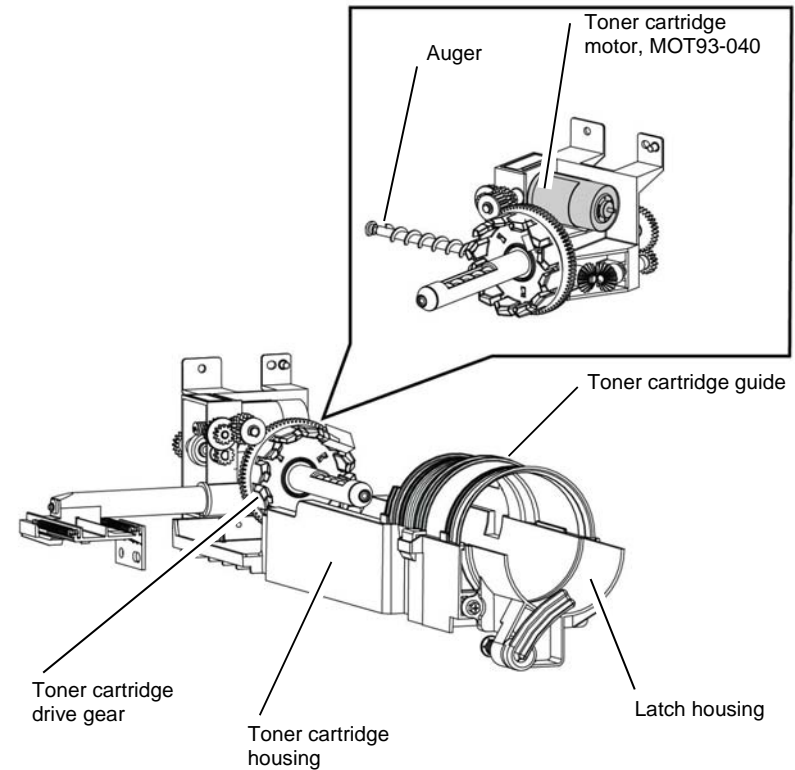
X-5-0125-A

Figure 3 Toner dispense assembly

If these values indicate that more toner is required, the toner cartridge motor, MOT93-040 will run. The motor rotates the toner cartridge (bottle) via the toner cartridge drive gear and drives the toner dispense auger. The auger delivers toner to the developer where it drops into a chute located on the print cartridge. When the TC sensor detects that there is the required amount of toner in the developer, the toner cartridge motor stops. Refer to [Figure 3](#) and [Figure 4](#).

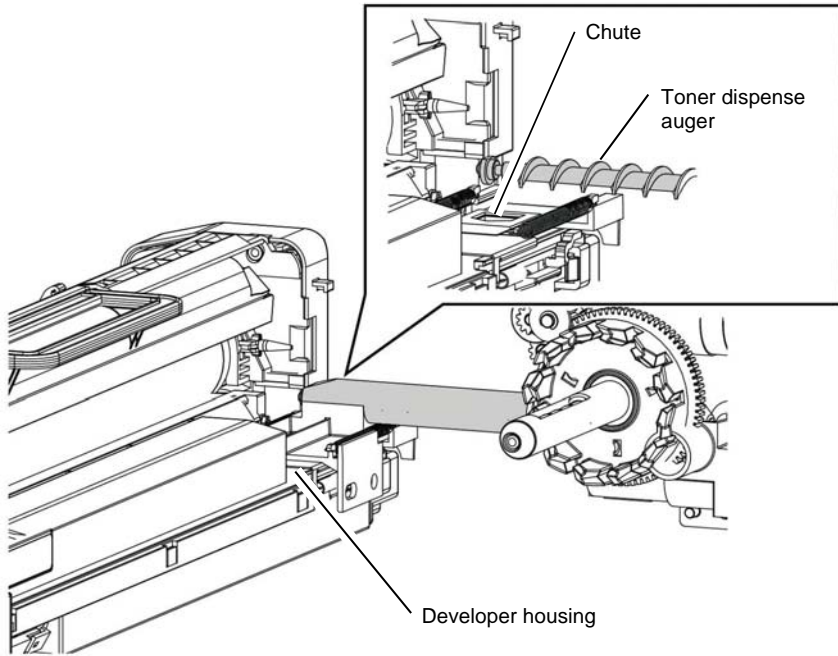
X-5-0126-A

Figure 4 Dispense auger and print cartridge

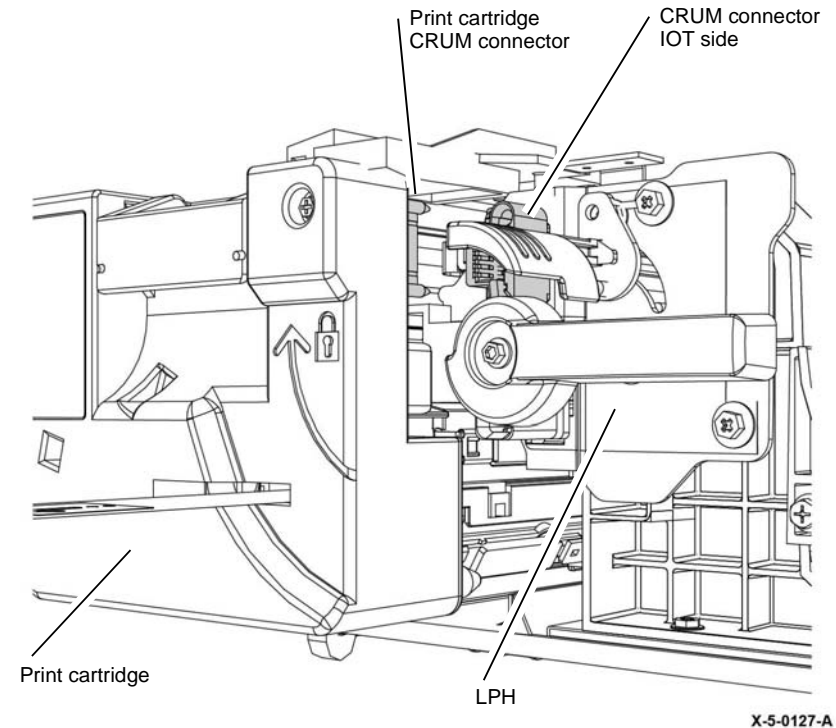
When the print cartridge is inserted into the machine, the CRUM connector on the cartridge is seated in the connector on the machine frame. The CRUM data is sent the IOT PWB via the serial data line (SDL) and data is written to the print cartridge CRUM. Refer to [Figure 5](#) for the location of the CRUM connectors.

Figure 5 Print cartridge CRUM connectors

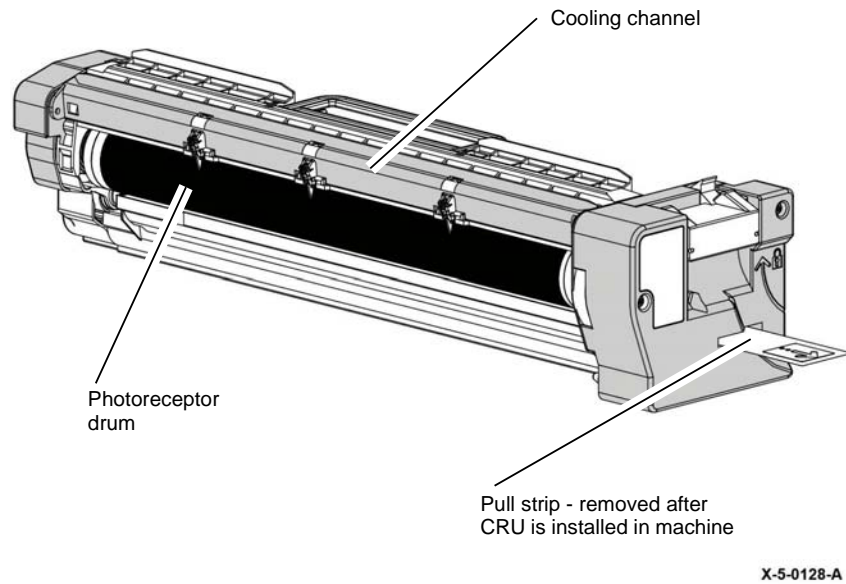
Refer to [Figure 6](#). The photoreceptor drum is an aluminium cylinder coated with a layer of photoconductive material that retains electrical charges on its surface until selectively exposed to infra-red pixels to create a latent image. An LED print head is used for exposure of the latent image on the drum.

Figure 6 Print cartridge CRU

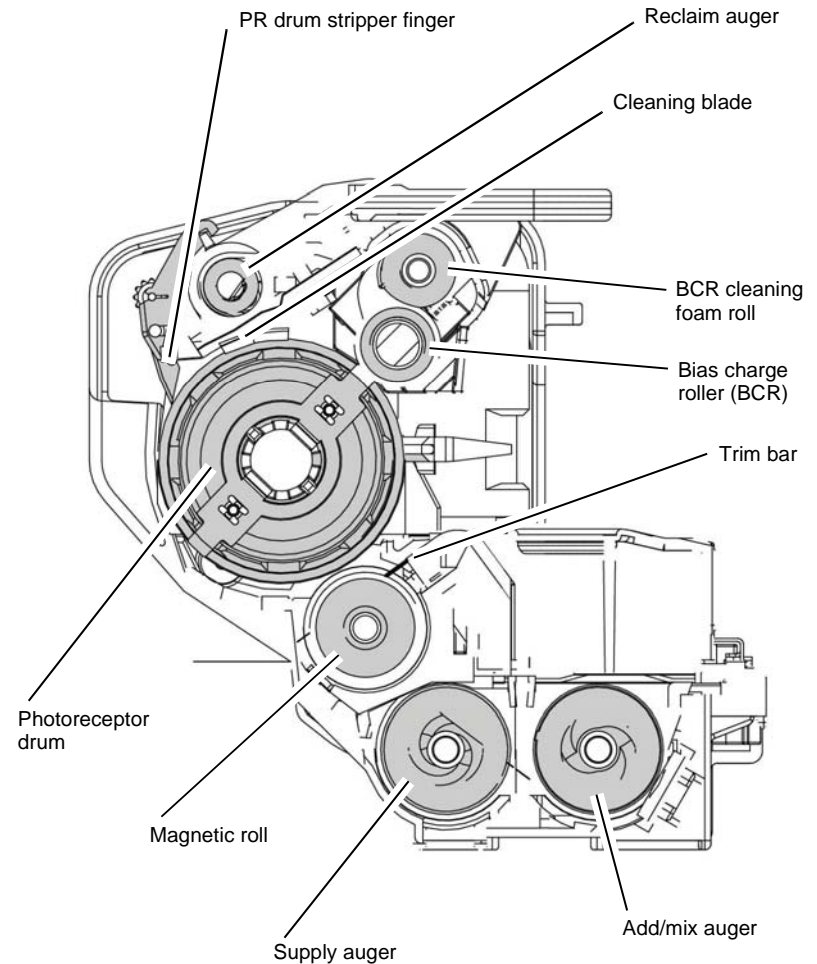
X-5-0129-A

Refer to [Figure 7](#). The supply auger delivers sufficient developer material to the mag roll.

Figure 7 Print cartridge cross section view

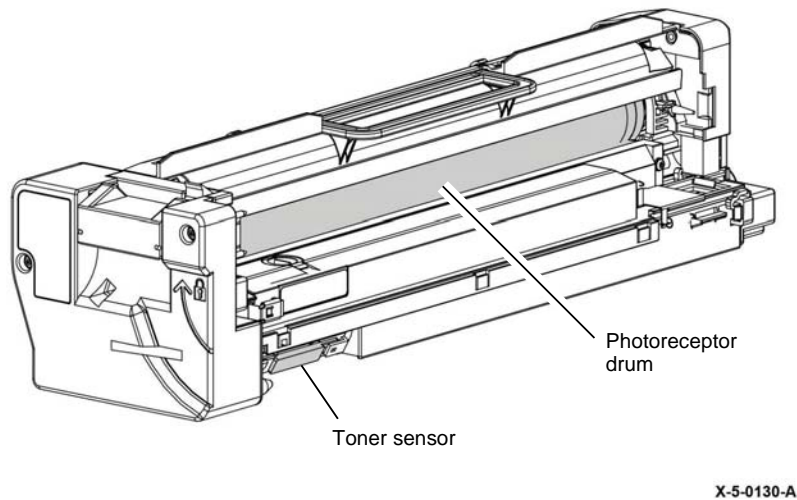
The toner sensor is a magnetic permeability sensor that measures toner concentration in the print cartridge. The output of this sensor feeds data into the process controls system of the machine which decides when and for how long to activate fresh toner introduction to the developer housing by pulsing on and off the dispense motor on the dispense module. Refer to [Figure 8](#).

Figure 8 Toner sensor

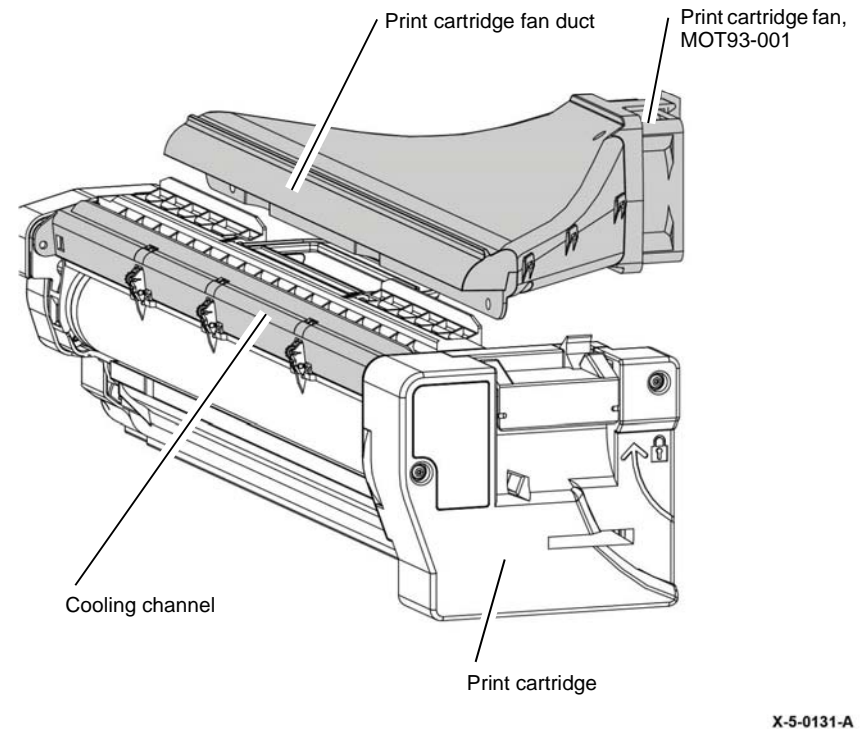
The print cartridge fan directs air through a duct and onto the print cartridge via the cooling channel. The print cartridge fan helps prevent overheating of the print cartridge and increases the life of the print cartridge.

A count is kept based on the media size and the number of simplex or duplex prints. The fan switches on once that count is exceeded. This is only likely to occur during long print runs. Otherwise the fan will only run after printing has finished.

Figure 9 Print cartridge cooling

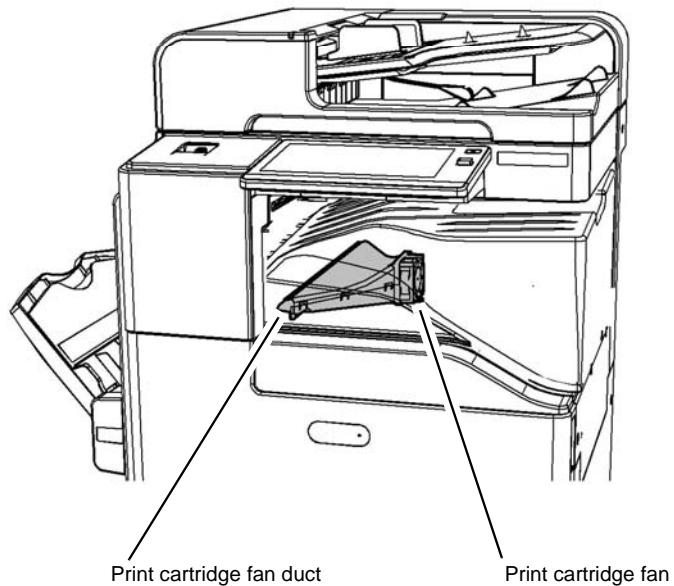
X-5-0177-A

The lower speed variants have a fan and duct blowing air onto the print cartridge. The air is taken from inside the machine and blown onto the print cartridge, [Figure 10](#).

Figure 10 Print head cooling 45/55 variants

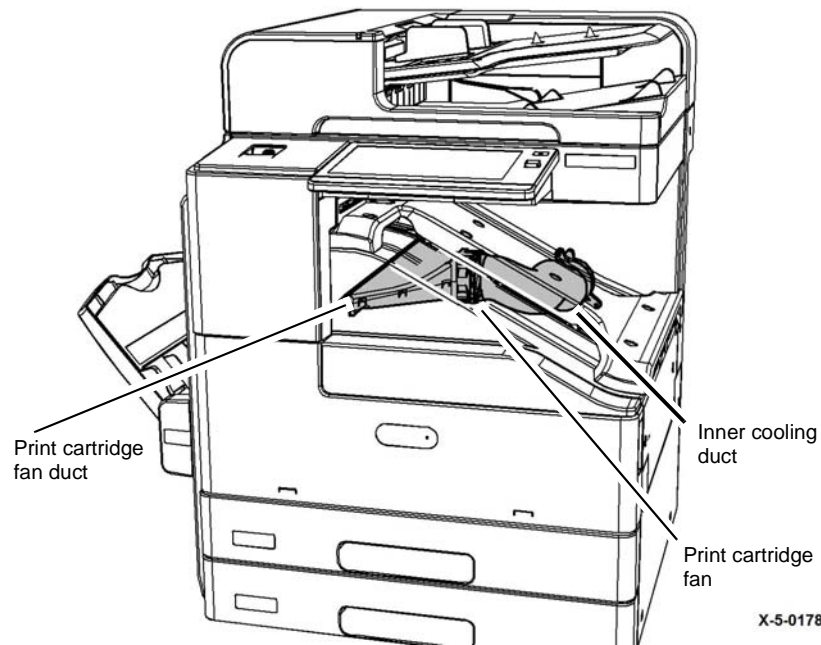
X-5-0178-A

The higher speed variants have a fan and duct blowing air onto the print cartridge. The air is taken from outside the machine at the rear via a duct and blown onto the print cartridge, [Figure 11](#).

Figure 11 Print head cooling 65/75/90 variants

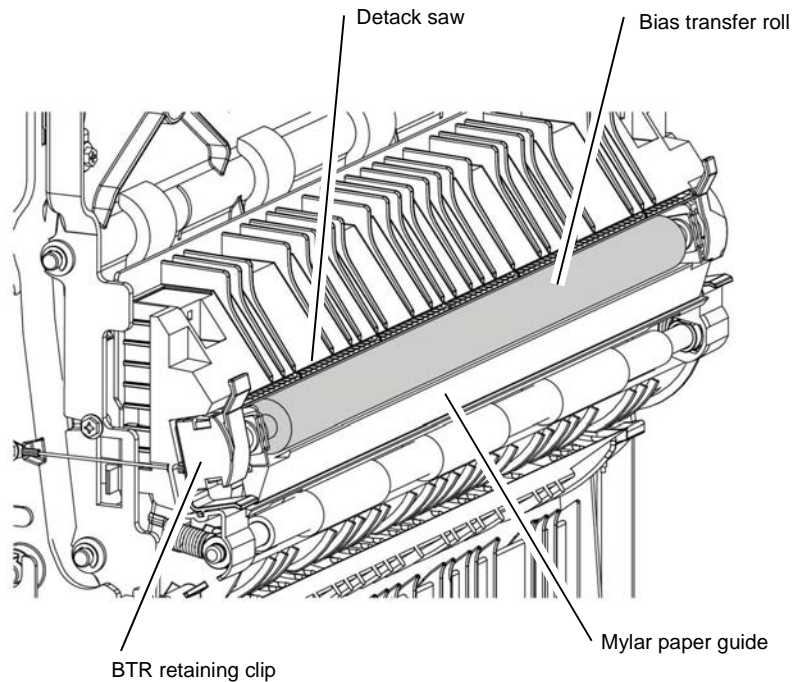
X-5-0132-A

Refer to [Figure 12](#). The bias transfer roll is located in the left door assembly. Drive for the transfer roller is accomplished by the roller being in direct contact with the photoreceptor drum. When paper moves between the bias transfer roll and photoreceptor drum, the bias transfer roll applies a positive charge to the rear surface of the paper. The negatively charged, developed image on the drum is attracted by the positive charge on the rear surface of the paper. Thus, the developed image is transferred from the surface of the drum to the surface of the paper. The detack saw, located adjacent and above the transfer roll, helps to separate the paper from the drum surface by introducing a stream of negatively charged ions onto the non-image side of the page.

Figure 12 Bias transfer roll

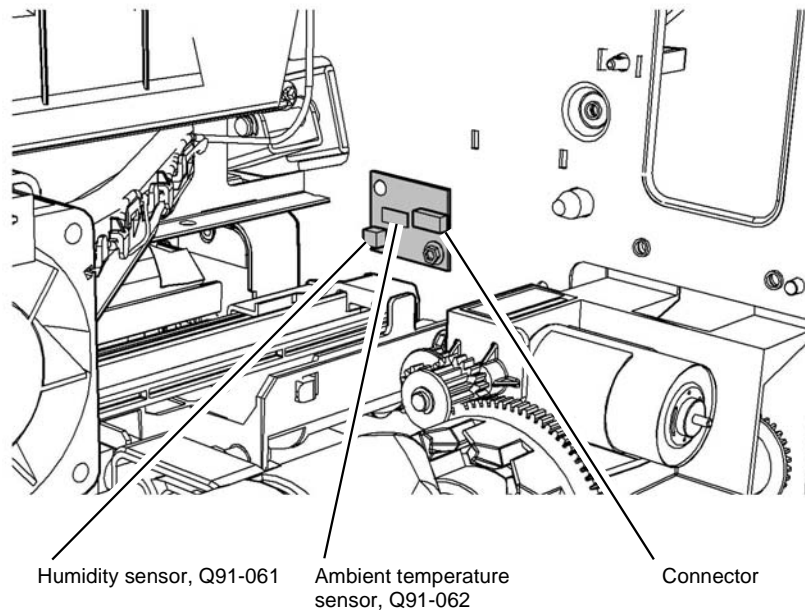
X-5-0133-A

Refer to [Figure 13](#). The ambient temperature sensor, Q91-062, and the humidity sensor, Q91-061, are mounted on the environmental sensors PWB.

The outputs for both the temperature and humidity sensors get converted to a 10-bit value by an A/D converter. The software then converts this bit value to degrees C and percentage RH. The measurement range of relative humidity is 30% to 80% and the temperature range is 5 to 50 degrees C.

Figure 13 Environmental sensors PWB
