Phaser® 6510, WorkCentre® 6515 Service Manual

Xerox Phaser 6510 Color Printer/WorkCentre 6515 Color Multifunction Printer

Phaser 6510 Color Printer/WorkCentre 6515 Color Multifunction Printer Service Manual

705P01382

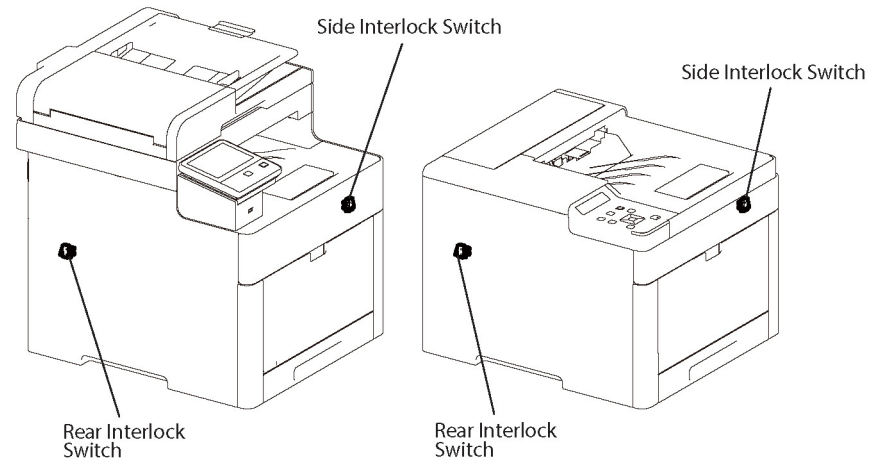
s6510_6515-283

Use caution so that the safety devices for preventing accidents (interlocks switches, fuses, thermostats, etc.) and the protective parts for users (covers, control panel, etc.) can function as intended. Make sure all covers are in place and all interlock switches are functioning correctly after you have completed a service call. If you bypass an interlock switch, use extreme caution when working on or around the printer. Figure 1 and Figure 2 show the interlock switch locations and circuitry.

Figure 1 Safety Interlock Switch Locations

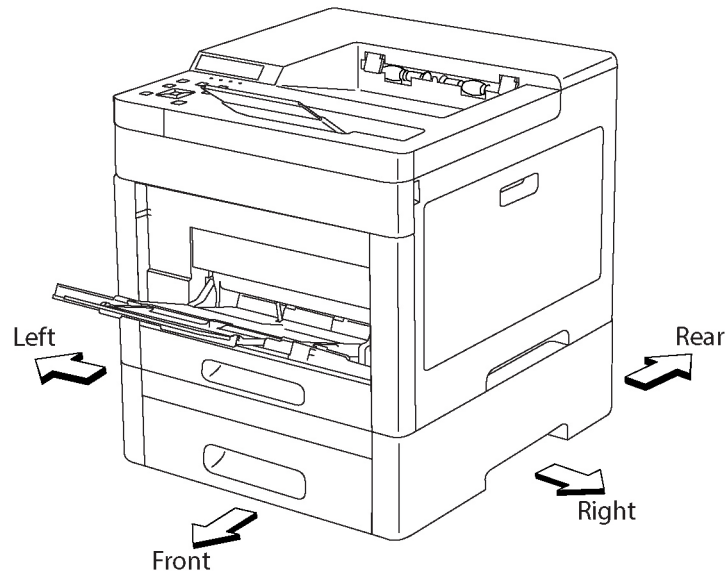
Figure 1 shows the standard orientation for the Phaser 6510. Directional descriptions used in the procedures are defined as follows:

Figure 1 Phaser 6510 Standard Orientation

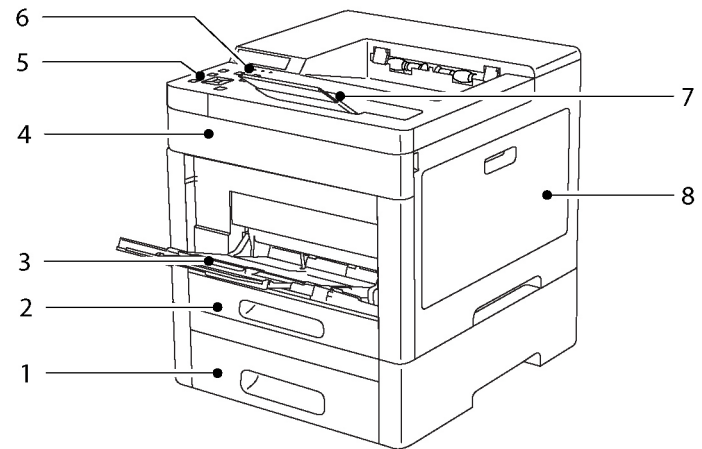
Figure 2 shows the printer's front and right side views with parts identified in Table 1.

Figure 2 Phaser 6510 Front and Right Side Views

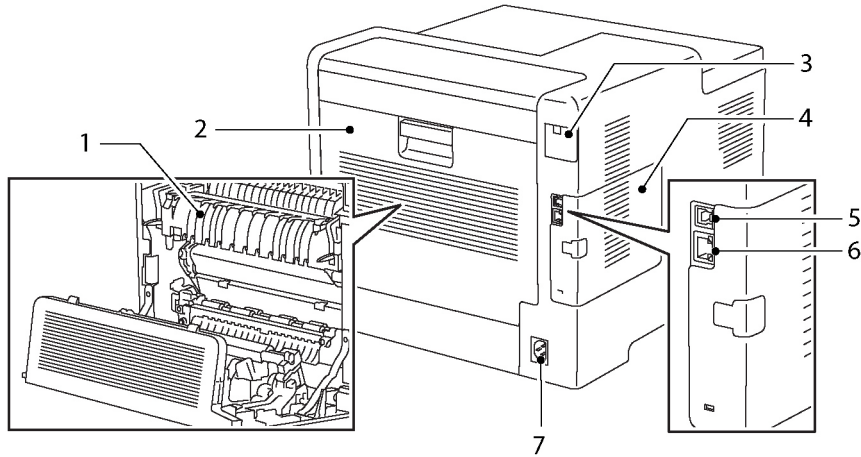
Figure 3 shows the printer's rear and left side views with parts identified in Table 2.

Figure 3 Phaser 6510 Rear and Left Side Views

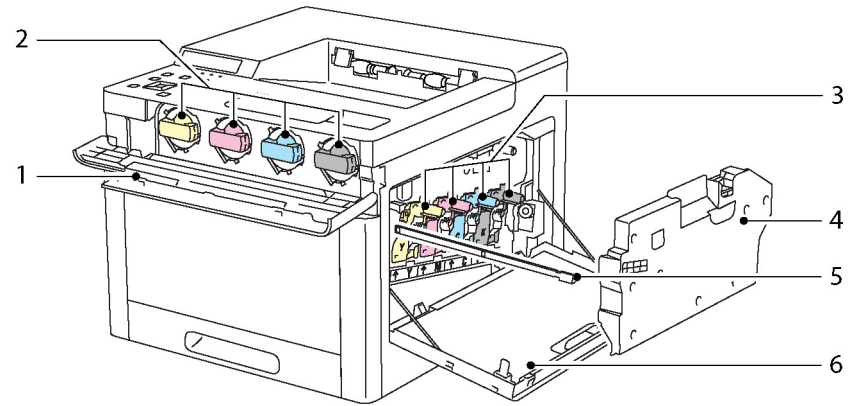
Figure 4 shows the printer's front and right side internal views with parts identified in Table 3.

Figure 4 Phaser 6510 Internal Parts

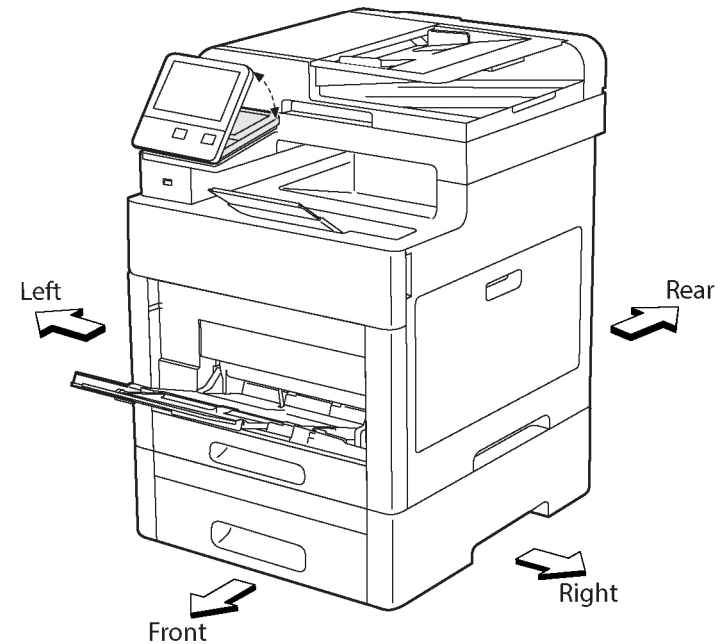
s6510_6515-285

Figure 6 shows the standard orientation for the WorkCentre 6515. Directional descriptions used in the procedures are defined as follows:

Figure 6 WorkCentre 6515 Standard Orientation

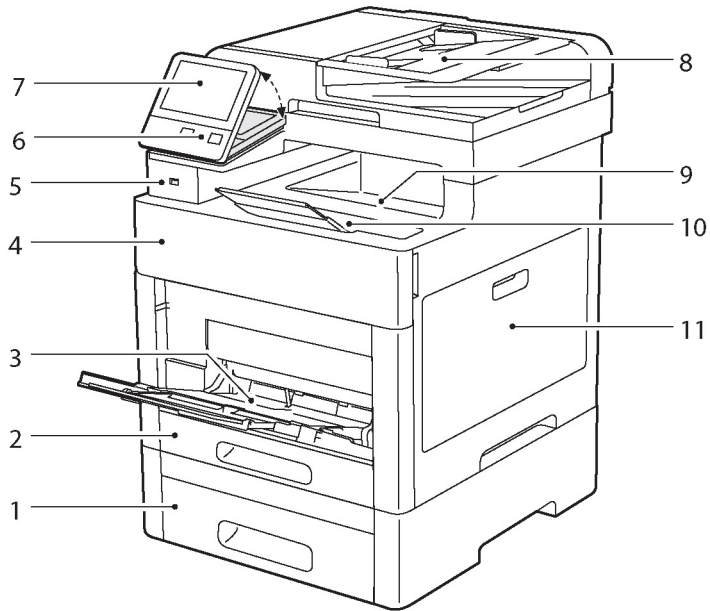
Figure 7 shows the printer's front and right side views with parts identified in Table 5.

Figure 7 WorkCentre 6515 Front and Right Side Views

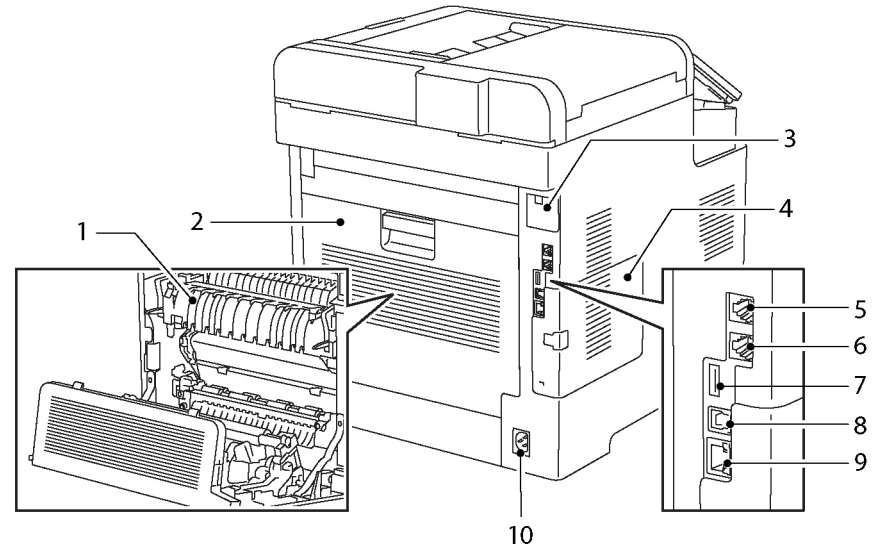
Figure 8 shows the printer's rear and left side views with parts identified in Table 6.

Figure 8 WorkCentre 6515 Rear and Left Side Views

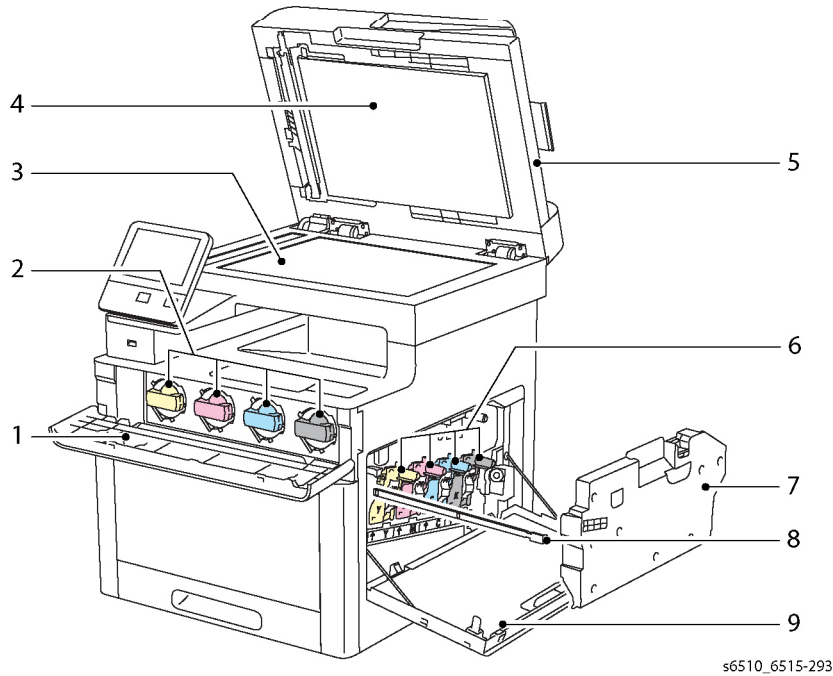
Figure 9 shows the printer's front and right side views with internal parts identified in Table 7.

Figure 9 WorkCentre 6515 Internal Parts

1. Toner Cover	6. Drum Cartridges (Y, M, C, K)
2. Toner Cartridges (Y, M, C, K)	7. Waste Cartridge
3. Platen	8. LPH Cleaning Rod
4. Document Cover	9. Waste Cartridge Cover
5. Single-Pass Duplex Automatic Document Feeder (DADF)

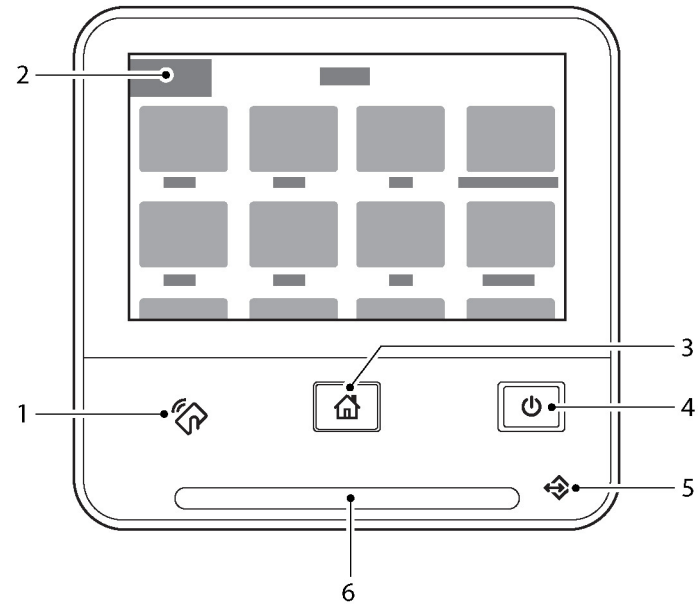
The WorkCentre 6515 Control Panel (Figure 10) consists of a touchscreen, a keypad, and several buttons. These buttons are used to navigate the menu system, perform functions, and select operational modes. Table 8 lists the function of each control.

Figure 10 WorkCentre 6515 Control Panel

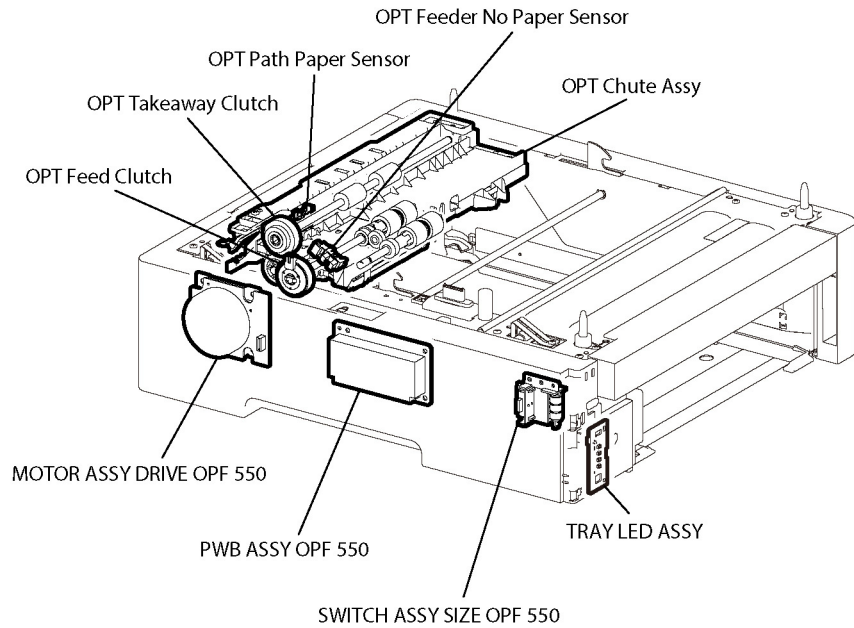
s6510_6515-281

The optional 550-sheet feeder increases media storage. One additional tray is supported.

Figure 1 Option 550-Sheet Feeder

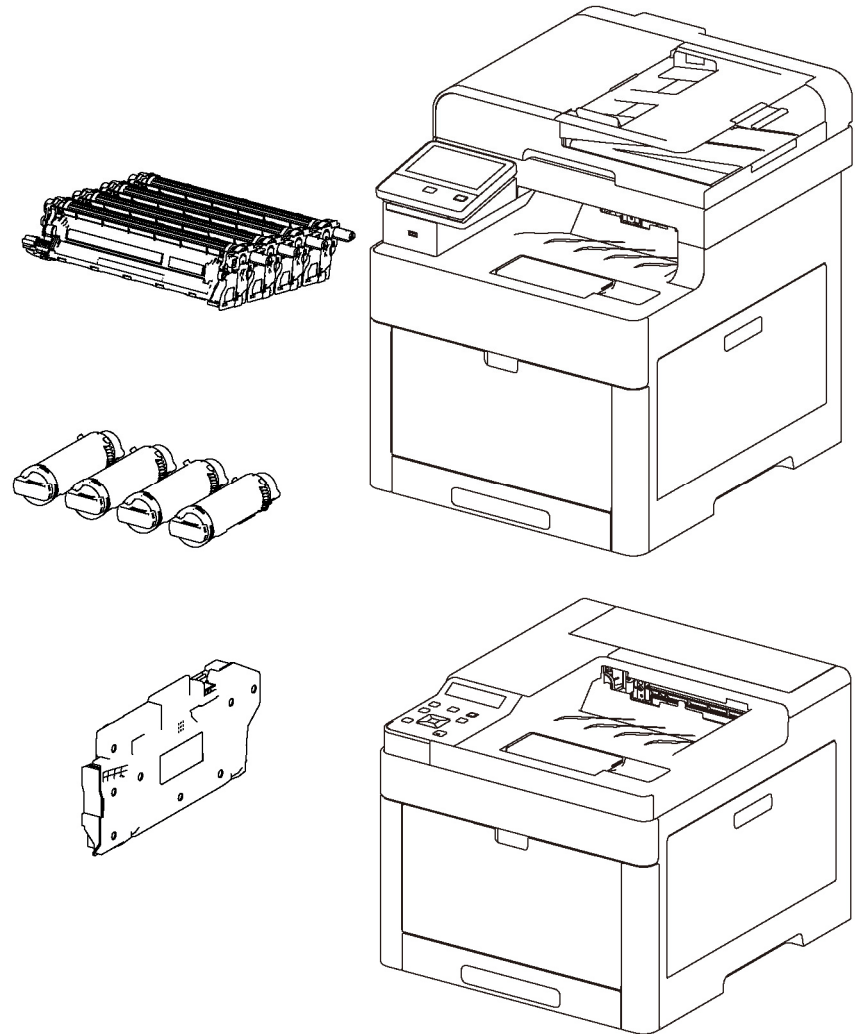
The printer has the following basic configurations (Figure 1) depending on the destination.

- Print engine main unit (MSI and 250 feeder unit as the standard paper feeding)
- Consumables (CRU)

Figure 1 Basic Configuration

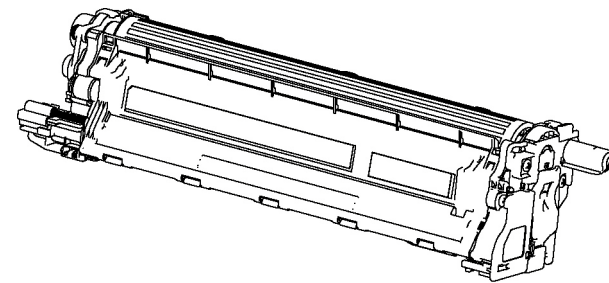
Figure 2 Drum Cartridge

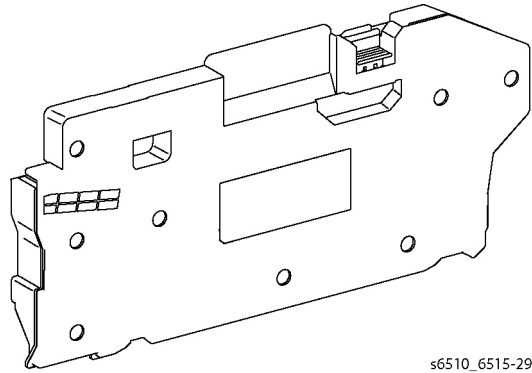
s6510_6515-299

Figure 3 Waste Cartridge

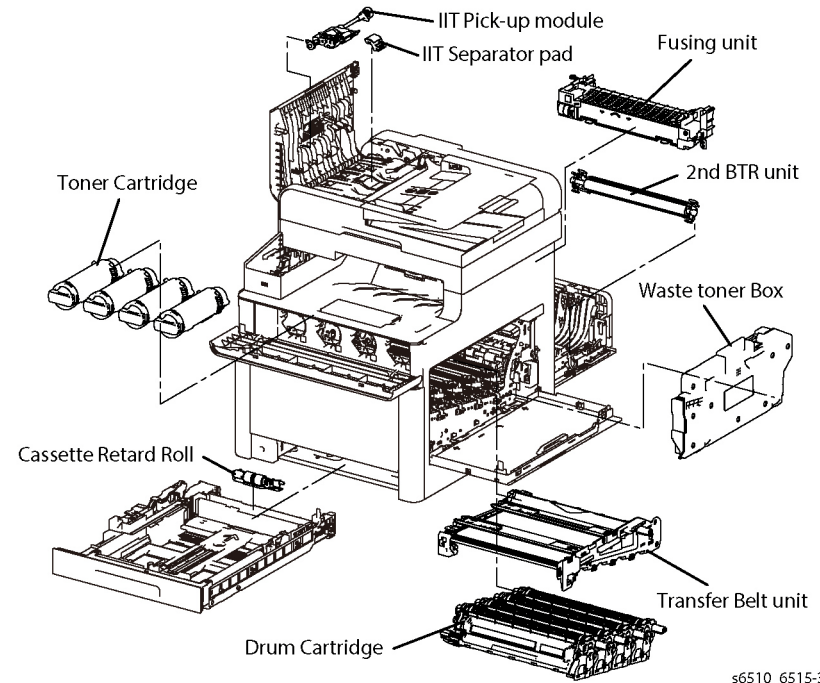
s6510_6515-300

Figure 4 and Figure 5 show the routine maintenance items which are service parts:

- Fuser (110V / 220V): 100 kPV (life of machine)
- Transfer Belt unit + Transfer Roller unit: 100 kPV (life of machine)
- DADF Feed Rollers: 100 kPV (WorkCentre 6515 only) (life of machine)

Figure 4 MFP Routine Maintenance Items

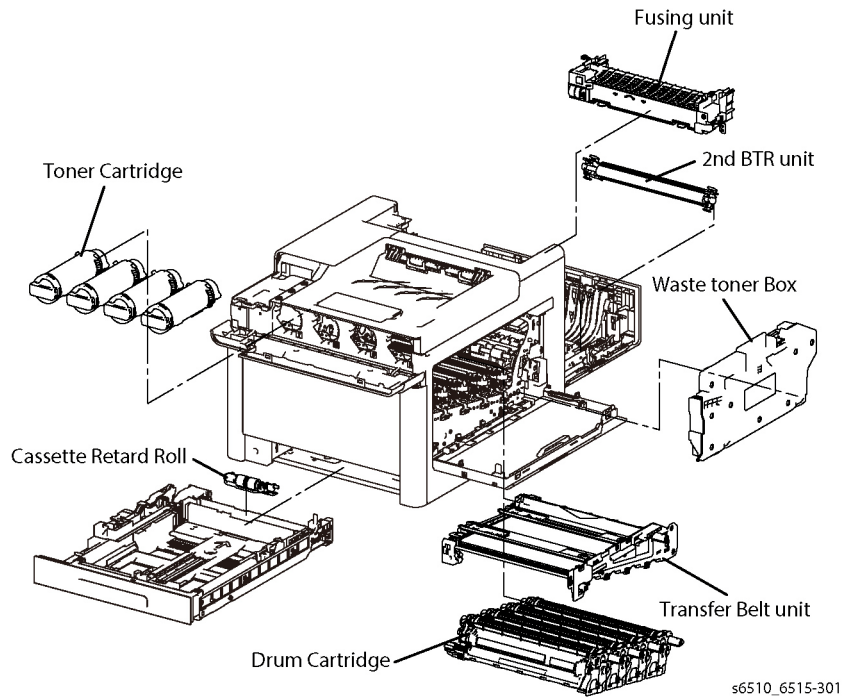
Figure 5 SFP Routine Maintenance Items

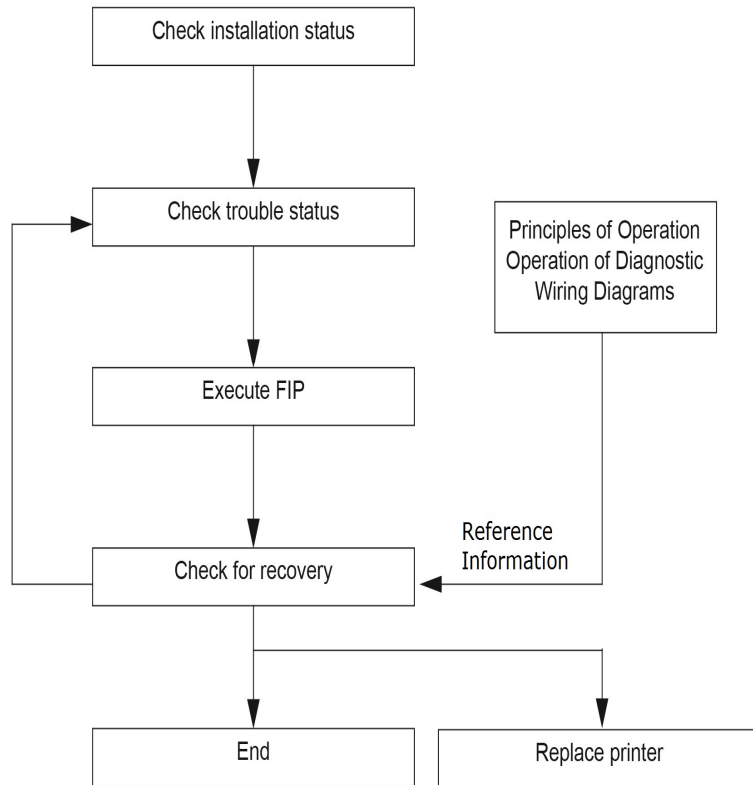
Figure 1

Flow of the troubleshooting is as follows:

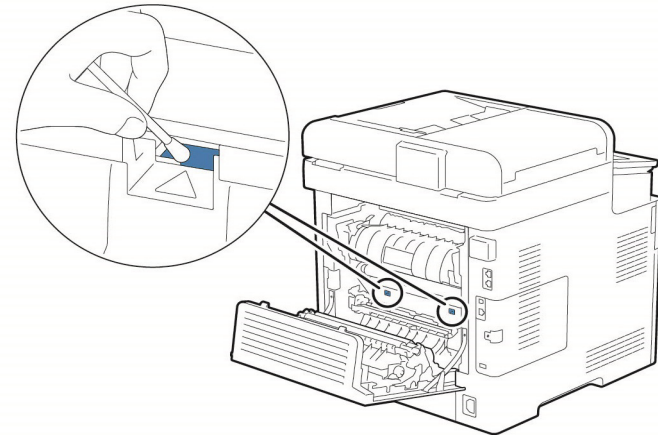
Clean the CTD (RAD) Sensor:

1. Turn the printer off, [GP 4]
2. Pull up the handle lever of the rear cover, and open the rear cover.
3. Clean the CTD sensor with a clean and dry cotton swab.

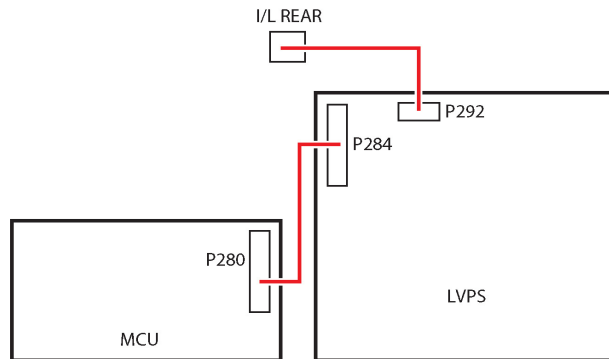
Figure 1

1. Enter [dC330], code 041-301. Check the Rear Interlock Switch operation [PL 18.3/4].
 - a. If the fault persists, install new components as necessary:
 - MCU Board, [PL 18.1/1], [REP 18.1.1](MFP), [PL 18.5/1], [REP 18.5.1](SFP)
 - b. Check the connection of the Rear Interlock Switch and the PWBA LVPS. Verify [P/J292] is fully seated. (Refer to [Figure 1]).
 - c. Check the connection of the PWBA LVPS and the MCU Board at [P/J284] and [P/J280] verify connections are fully seated and continuity of the cables between [P/J284] <=>[P/J280].
 - i. Install a new LV MCU HARNESS ASSY [PL 18.4/5].
 - d. Install a new Rear Interlock Switch, [PL 18.3/4], [REP 18.3.4](MFP), [PL 18.7/4], [REP 18.7.4](SFP)
 - i. Install a new LVPS Board [PL 18.1/16] [REP 18.1.16](MFP), [PL 18.5/16] [REP 18.5.16](SFP).

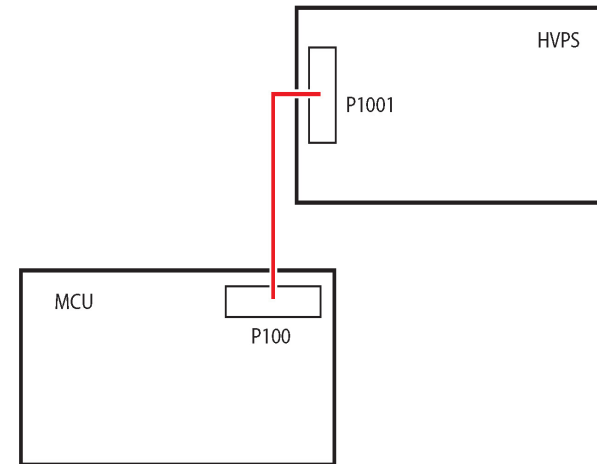
Figure 1

1. Power down the power up the machine, [GP 4].
2. Check the connection between the PWBA HVPS and the MCU Board, verify [P/J100] and [P/J1001] are fully seated. (Refer to [Figure 1]).
3. Check the continuity of the harness between [P/J100] and [P/J1001].
 - a. Install a new MCU-HVPS-C HARNESS ASSY [REP 18.4.2] (MFP) , [REP 18.8.2] (SFP).
4. Install a new HVPS Board A (SCC) [REP 18.2.1](MFP), [REP 18.6.1](SFP)
5. If the fault persists, install a new MCU Board [REP 18.1.1](MFP), [REP 18.5.1](SFP)

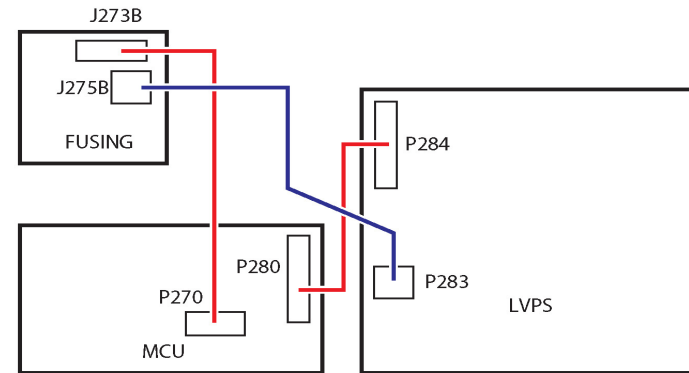
Figure 1

4. Verify the HARNESS ASSY FUSING ASSY [PL 18.3/1](MFP), [PL 18.7/1](SFP), continuity in each cable of [P/J283] <=>[P/J275].
5. Verify the LV MCU HARNESS ASSY [PL 18.4/5](MFP), [PL 18.8/5](SFP), continuity in each cable of [P/J284] <=>[P/J280].

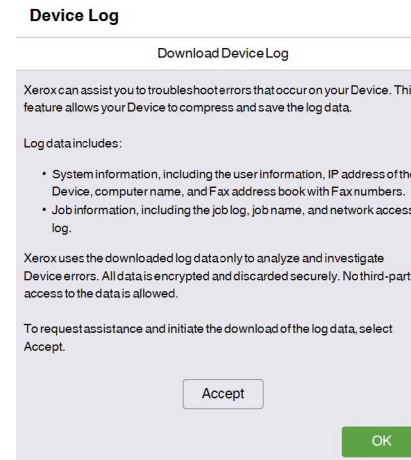
Figure 4

- c. The collected Audit Log File (.txt) is saved.
7. Collect the Device Log. Select Device Log in Logs Menu.
 - The following window appears. (Figure 4)

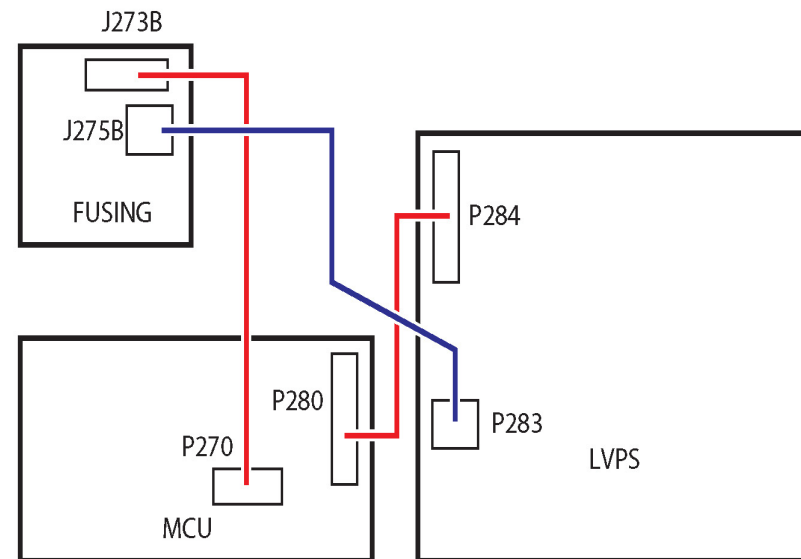
Figure 1

1. Verify the FUSING ASSY and the drawer connector of the printer are installed properly (without a bent pin, or any foreign or burnt objects, etc.).
2. Check the connection between the FUSING ASSY and the MCU Board and FUSING ASSY and LVPS Board ([P/J283], [P/J275], [P/J270], and [P/J273]) are fully seated. (Refer to Figure 1).
3. Check the connection between the LVPS Board and the MCU Board ([P/J284], [P/J280]) are fully seated.
4. Check the continuity between the Fuser Harness (AC) 110VAC in each cable of [P/J283] <=>[P/J275].
 - Install a new Fuser Harness (AC) 110VAC.
5. Check the continuity between the LV MCU Harness Assy (J280-J284) in each cable of [P/J284] <=>[P/J280].
 - Install a new LV MCU HARNESS ASSY [PL 18.4/5].
6. Install a new MCU Board, [REP 18.1.1](MFP), [REP 18.5.1](SFP)
7. Install a new LVPS Board [REP 18.1.16](MFP) [REP 18.5.16](SFP)

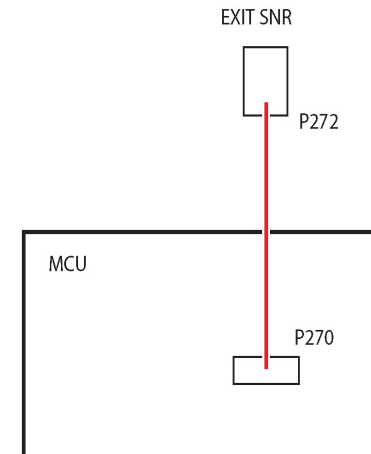
Figure 1

- Install a new LV MCU HARNESS ASSY, REP 18.4.5(MFP) [REP 18.8.5](SFP).
 - c. Close all interlock switches and verify the voltage from the LVPS Board ground and the [P/J284]-18 pin and the voltage from the LVPS Board ground and the P/J284-20 pin is about +24 VDC.

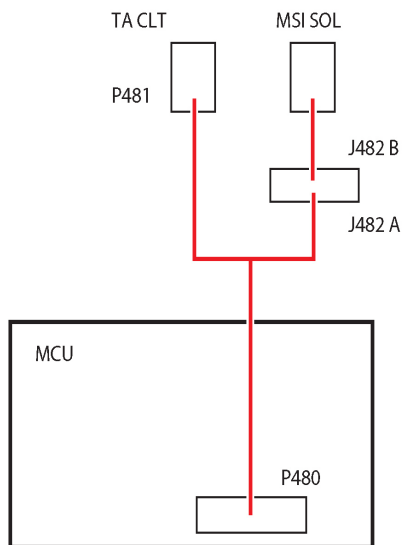
Figure 1

- Install a new LV MCU HARNESS ASSY [PL 18.4/5].
 - c. Close all interlock switches and check the voltage from the LVPS Board (+24 VDC). Voltage between the LVPS Board ground and the [P/J284]-20 pin should be about +24 VDC.

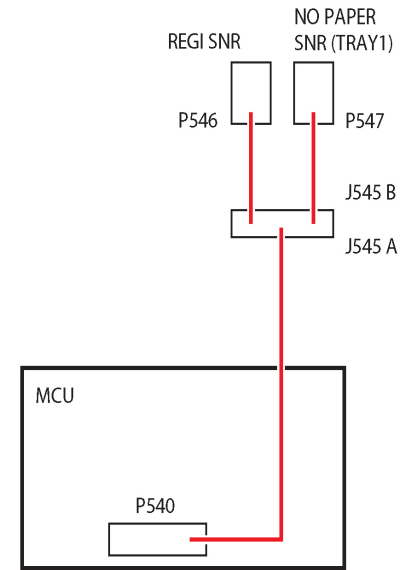
Figure 1

- c. Close all interlock switches and verify the voltage from the LVPS Board ground and the [P/J284]-18 pin and the voltage from the LVPS Board ground and the [P/J284]-20 pin is about +24 VDC.
- If the fault persists, install new components as necessary:
 - MCU Board, [REP 18.1.1](MFP), [REP 18.5.1](SFP)
 - Install a new LVPS Board [REP 18.1.16](MFP) [REP 18.5.16](SFP)

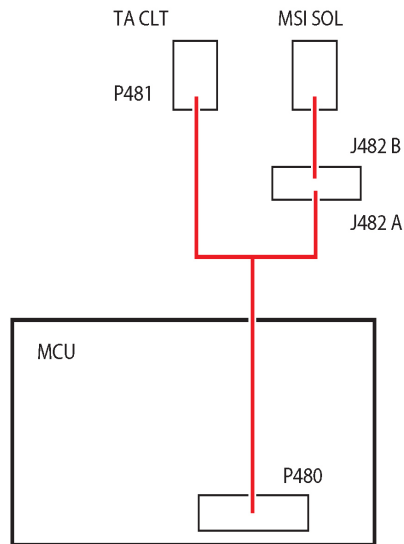
Figure 1

- Install a new LV MCU HARNESS ASSY [PL 18.4/5].
 - c. Close all interlock switches and check the voltage from the LVPS Board (+24 VDC). Voltage between the LVPS Board ground and the [P/J284]-20 pin should be about +24 VDC.

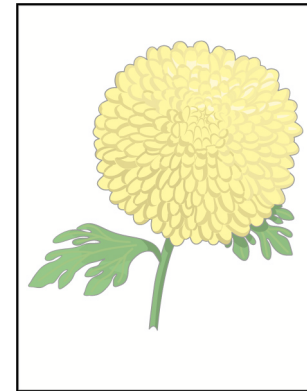
Figure 1 Light or Undertoned Print Example

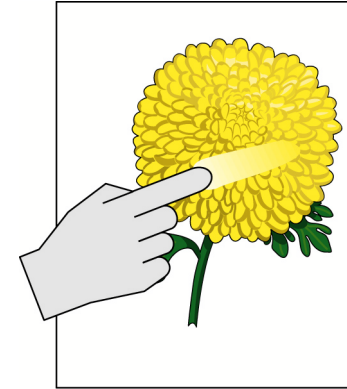
Figure 1 Unfused Image Example

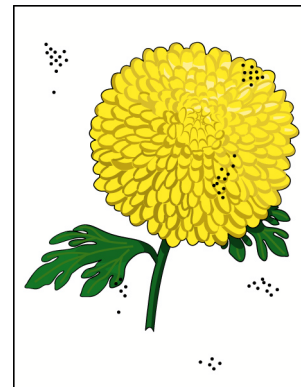
Figure 1 Random Spots Example

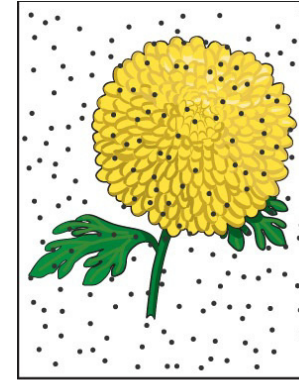
Figure 1 Bead Carry-Out Example

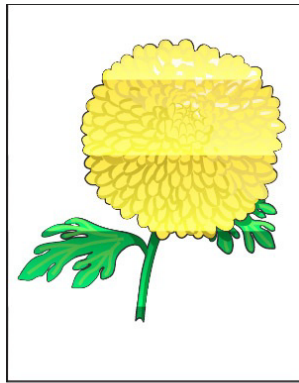
Figure 1 Light-Induced Fatigue Example

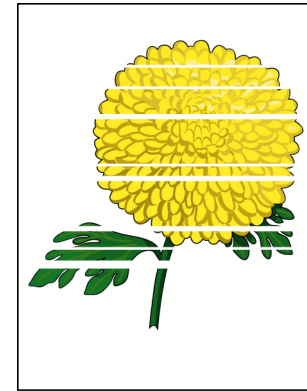
Figure 2 Horizontal Bands, Voids, or Streaks Example

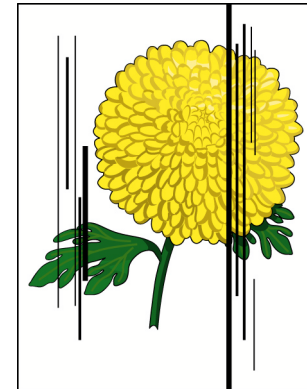
Figure 1 Vertical Streaks Example

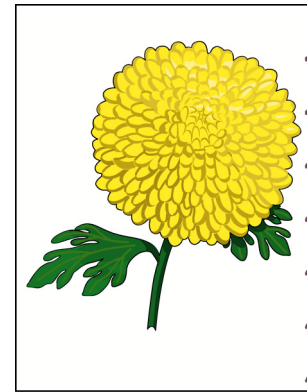
Figure 1 Cyclic Dot/Line Example

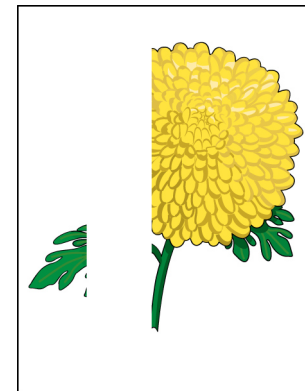
Figure 1 Vertical Blank Deletions (Line or Streak) Example

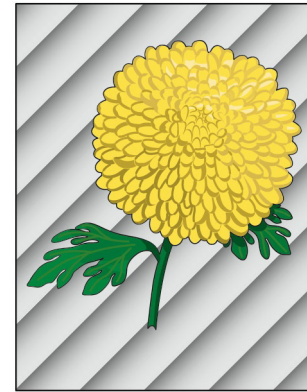
Figure 1 Diagonal Banding (Auger Marks) Example

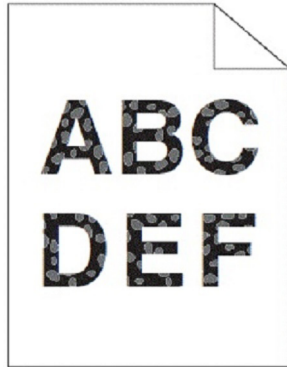
Figure 1 Uneven Density Example

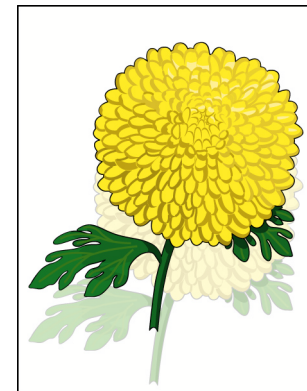
Figure 1 Ghosting Example

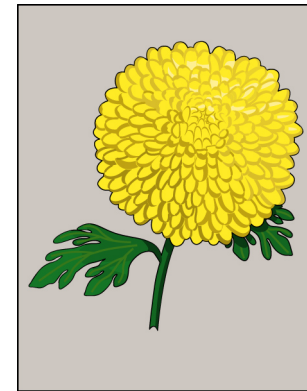
Figure 1 High Background Contamination Example

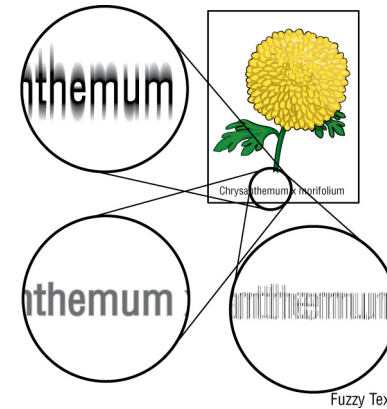
Figure 1 Fuzzy/Blurry Text and Image Example

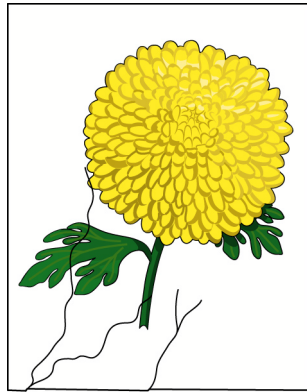
Figure 1 Wrinkled or Creased Example

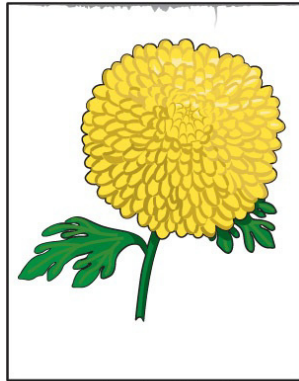
The page exits with the leading edge damaged (Figure 1).

Leading Edge Damage

Figure 1 Leading Edge Paper Damage Example

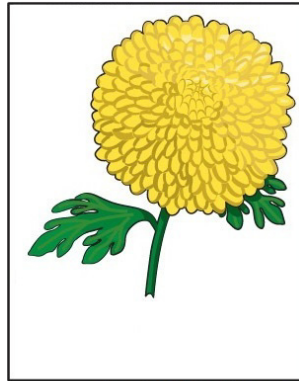
Image Not Centered

Figure 1 Incorrect Position or Margins Example

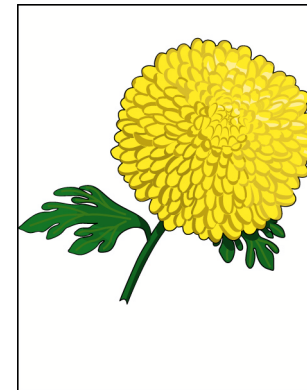
Skew 2

Figure 1 Skewed Image Example

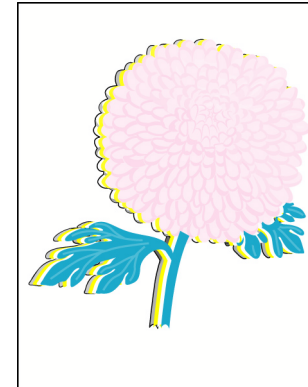
Color Registration

Figure 1 Color Registration Misalignment Example

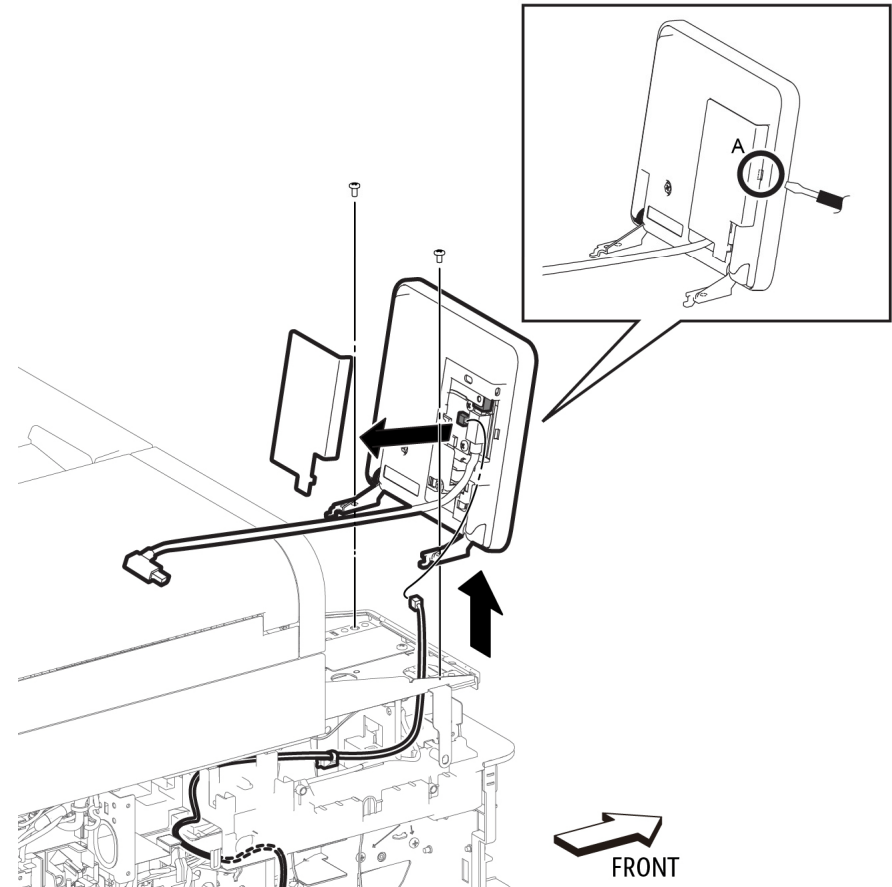
1. Verify the FW version before and after replacement of the UI, print a configuration page before starting removal.
2. Remove the Left Side Cover, REP 19.2.1.
3. Remove the Left Side IIT Cover, REP 19.2.4.
4. Remove the UI Inner Cover, REP 1.1.2.
5. Remove the UI Access Door from the console, REP 1.1.7.
6. Refer to Figure 1 to release the UI Harness and the Speaker Harness from the console.

Figure 1 Remove the UI Console Assembly (MFP)

7. Refer to Figure 1 to remove two screws (silver, M4x6mm) attaching the UI Console Assembly to the UI Frame Assembly.
8. Remove the UI Console Assembly from the UI Frame Assembly.

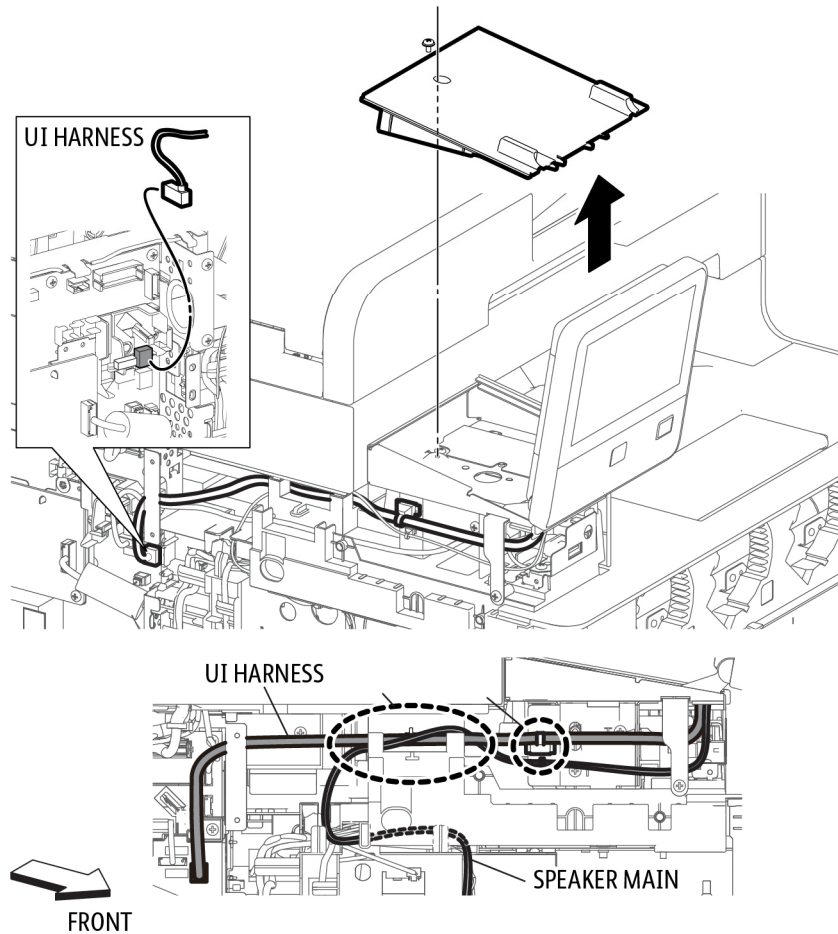
s6510_6515-001

1. Remove the Left Side IIT Cover, REP 19.2.4.
2. Refer to Figure 1 to remove one screw (black, M3x6mm) attaching the UI Inner Cover to the UI Frame Assembly, and remove the cover.

Figure 1 Remove the UI Inner Cover

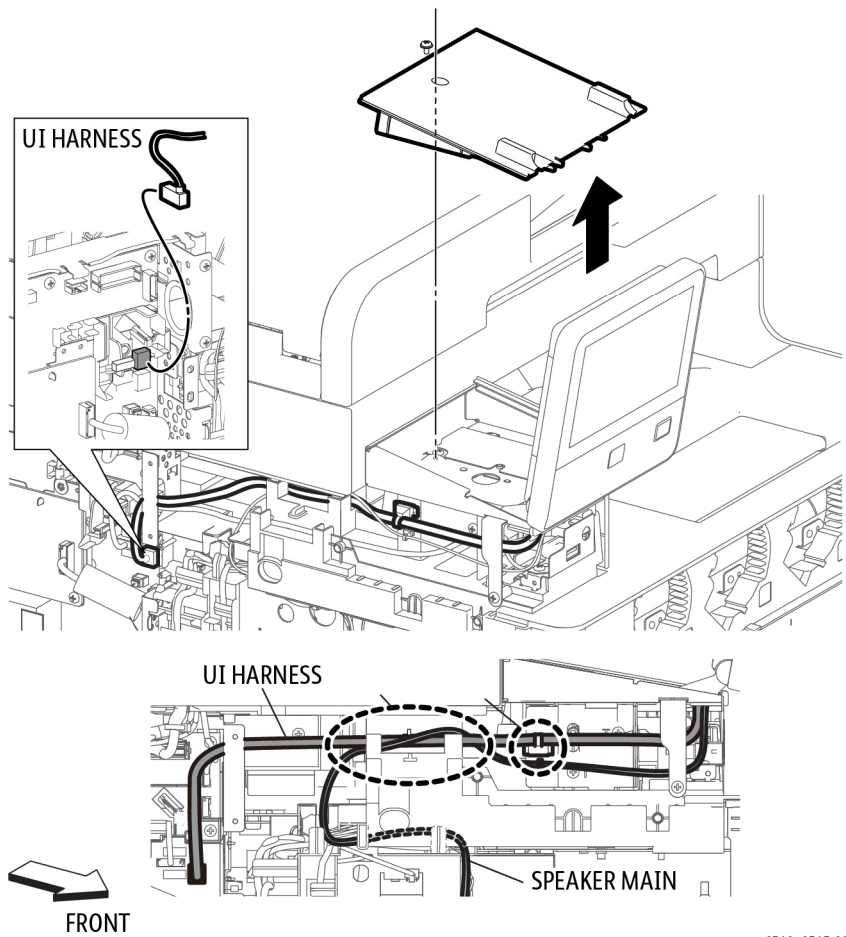
s6510_6515-001

1. Remove the Left Side Cover, REP 19.2.1.
2. Remove the ESS Top Plate, REP 18.1.18.
3. Remove the Left Side IIT Cover, REP 19.2.4.
4. Remove the UI Access Door, REP 1.1.7.
5. Remove the UI Inner Cover, REP 1.1.2.
6. Refer to Figure 1 to unplug the UI Harness from the ESS Board.

Figure 1 Release the UI Harness from the Printer (MFP)

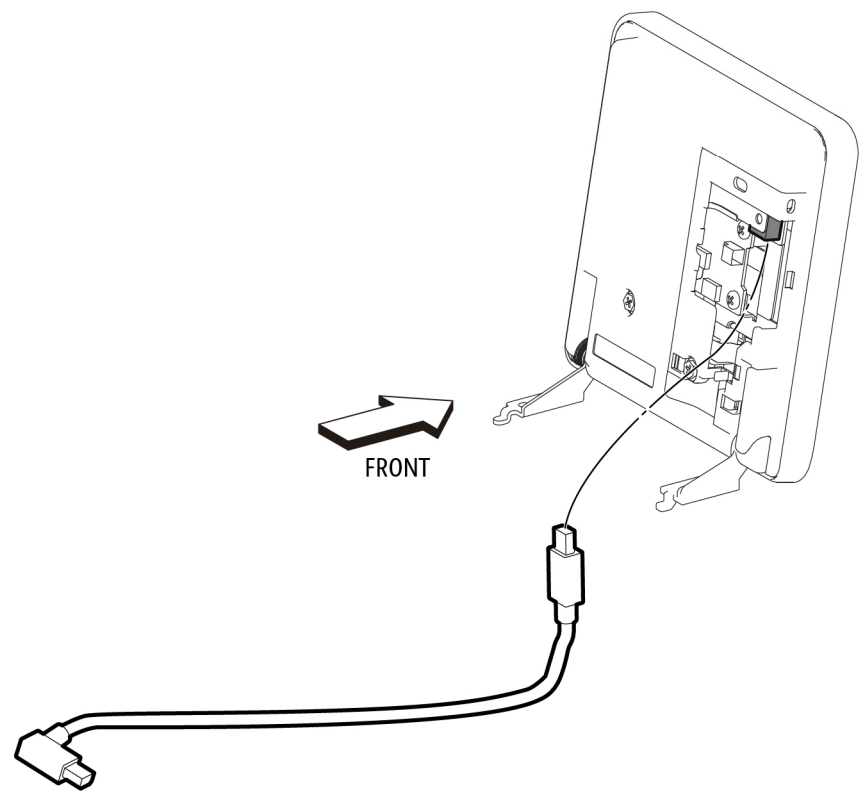
s6510_6515-003

7. Release the harness clamp from the UI Frame Assembly.
8. Remove the harness from the guide on the Top Cover Assembly.
9. Refer to Figure 2 to unplug the top end of the UI Harness from the UI Console Assembly and remove the harness.

Figure 2 Remove the UI Harness (MFP)

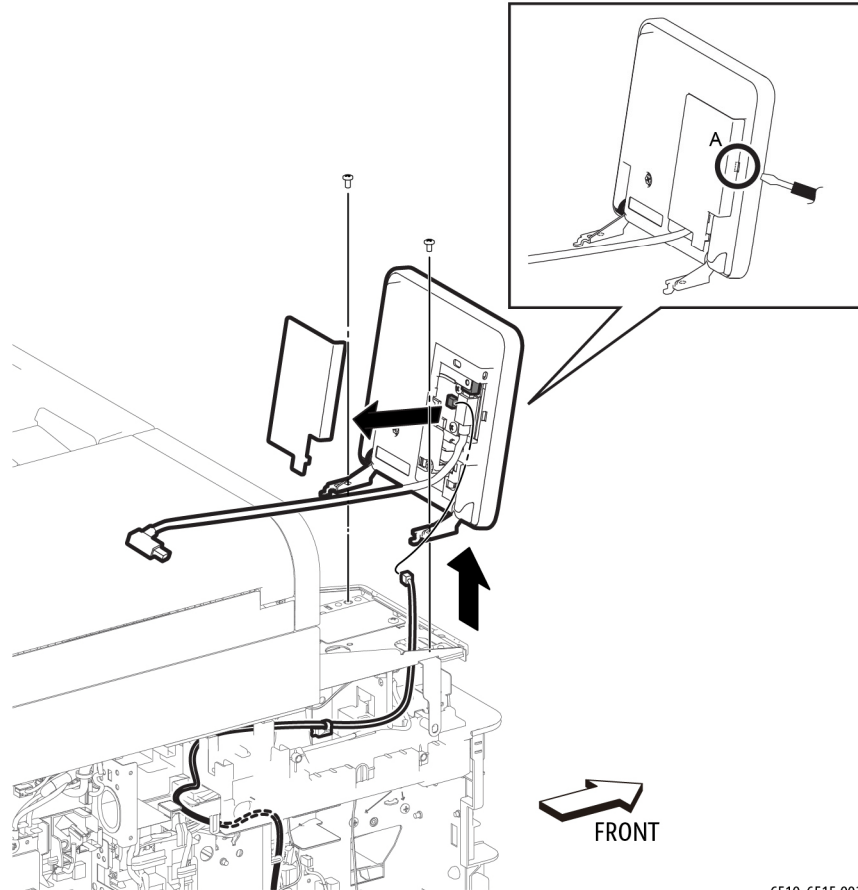
1. Refer to Figure 1 to insert a flat blade screwdriver at the side of the UI Access Door and slightly open the UI Access Door.

Figure 1 Remove the UI Access Door (MFP)

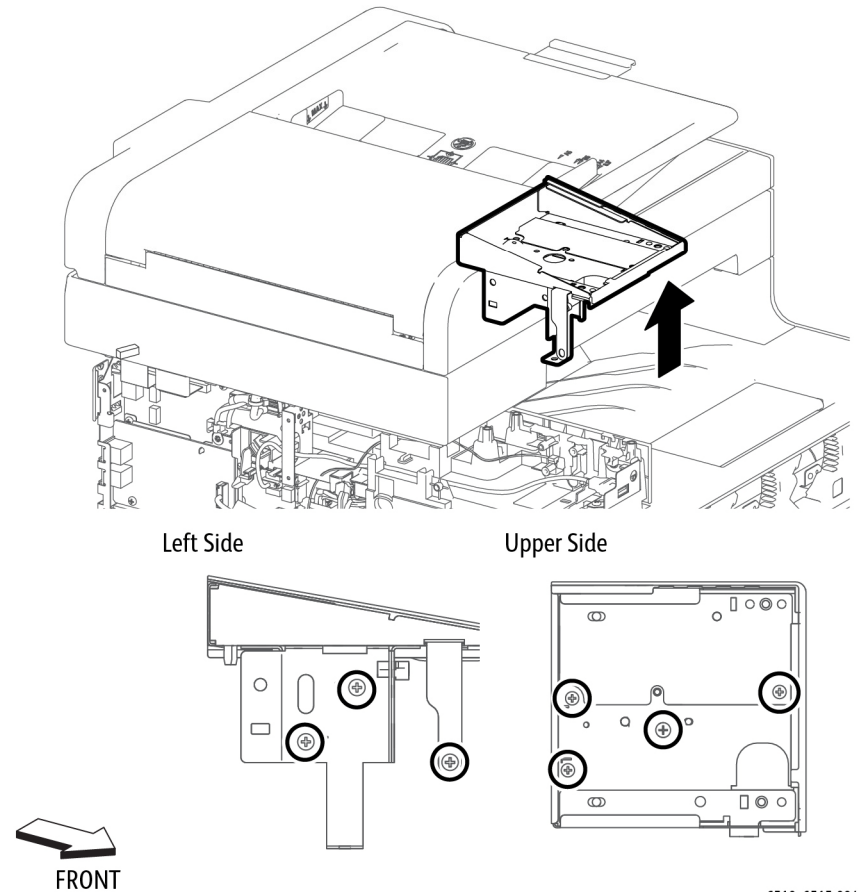
1. Remove the UI Console Assembly, REP 1.1.1.
2. Refer to Figure 1 to remove the three screws (silver, tapping, M3x8mm) attaching the left side of the UI Frame Assembly.

Figure 1 Remove the UI Frame Assembly (MFP)

3. Refer to Figure 1 to remove the three screws (silver, tapping, M3x8mm) from the top surface of the UI Frame Assembly.
4. Refer to Figure 1 to remove one screw (silver, M4x6mm) through the top access hole in the UI Frame Assembly attaching the frame's lower support arm.
5. Slide the UI Frame Assembly slightly to the left side while lifting up to remove the frame assembly with the attached UI Frame Cover.

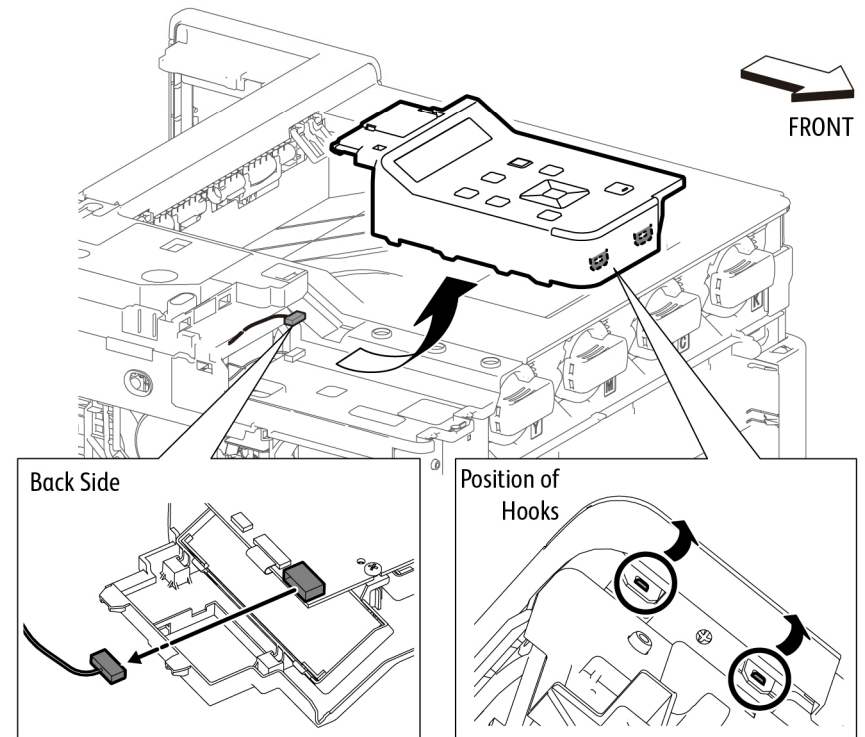
s6510_6515-005

1. Remove the Left Rear Top Cover, REP 19.3.24.
2. Open the Toner Cover.
3. Refer to Figure 1 to release the two hooks in the direction of the arrows and slightly lift up the UI Console Assembly.

Figure 1 Remove the UI Console Assembly (SFP)

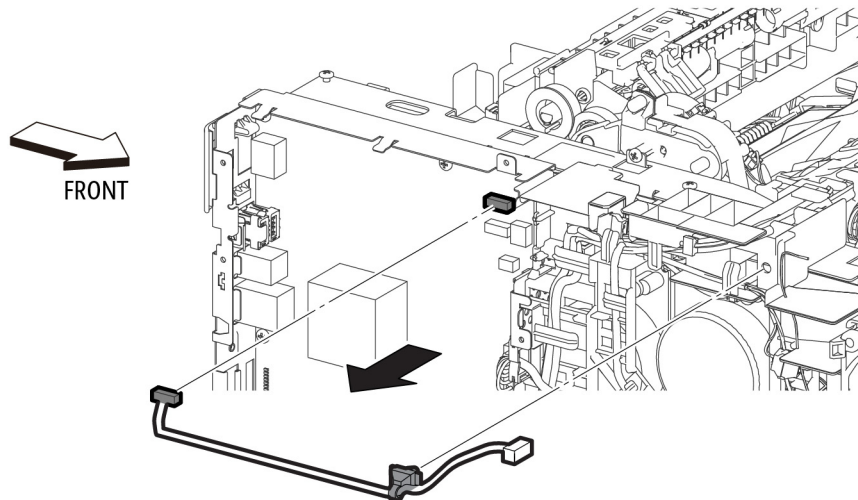
s6510_6515-006

1. Remove the UI Console Assembly, REP 1.2.1.
2. Remove the Left Side Cover, REP 19.4.1.
3. Remove the Top Cover, REP 19.3.99.
4. Remove the ESS Top Plate, REP 18.1.18.
5. Refer to Figure 1 to unplug the lower end of the UI Harness from the ESS Board.

Figure 1 Remove the UI Harness Assembly (SFP)

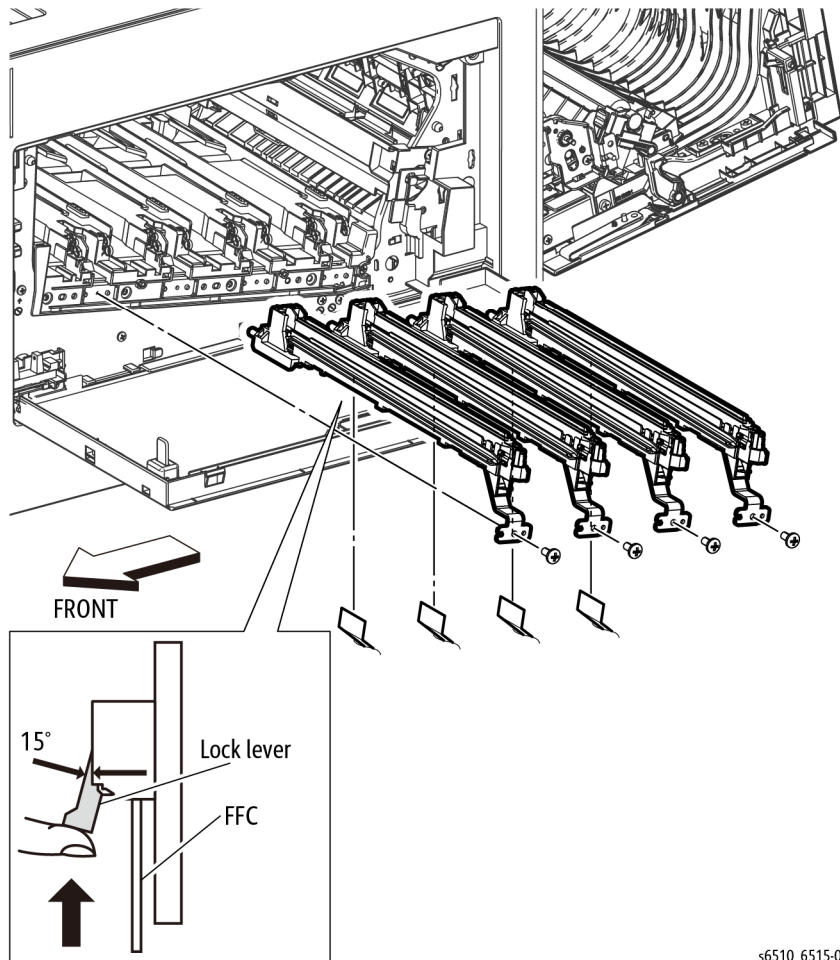
s6510_6515-007

4. Refer to Figure 1 to remove four screws (silver, M3x6mm) from the LPH Color Head Assembly.

Figure 1 Remove the LPH Color Head Assembly

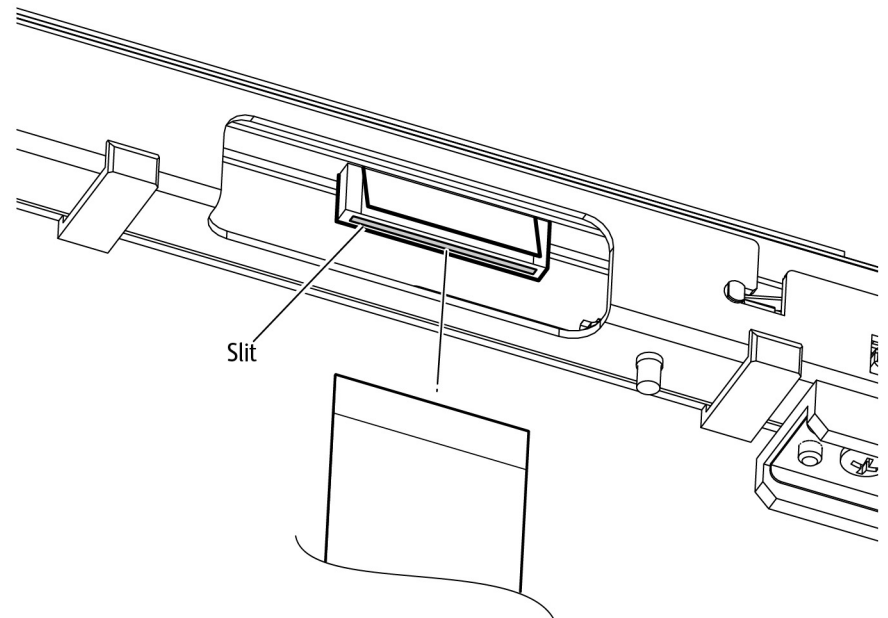
s6510_6515-008

When reconnecting the FFC, there is no need to release the lock lever. Insert the FFC vertically into the correct slit until seated with a click as shown in Figure 2.

Figure 2 Reconnect the LPH Color Head FFC
