Phaser® 6510, WorkCentre® 6515 Service Manual

Xerox Phaser 6510 Color Printer/WorkCentre 6515 Color Multifunction Printer

Phaser 6510 Color Printer/WorkCentre 6515 Color Multifunction Printer Service Manual

705P01382

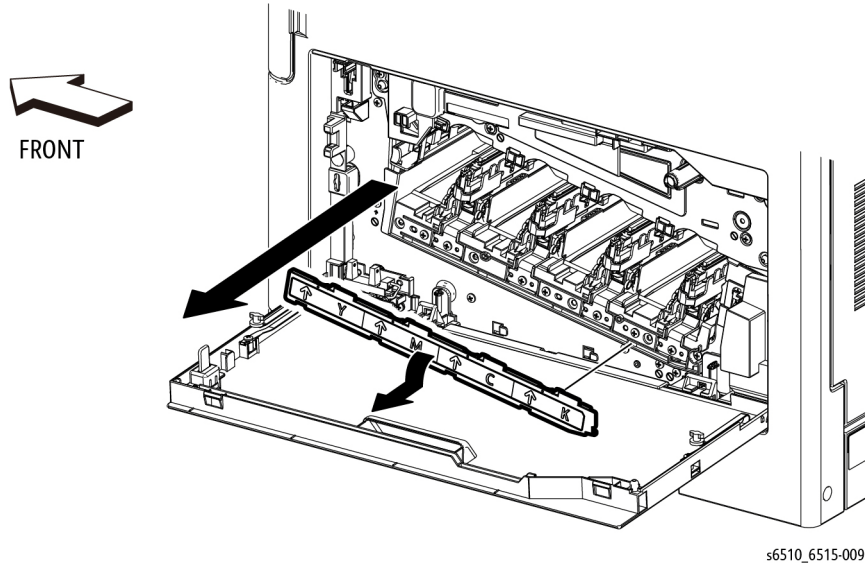
s6510_6515-009

1. Remove the Right Side Cover; REP 19.1.97 (MFP), REP 19.3.97 (SFP).
2. Refer to Figure 1 to remove the Guide Cover Assembly, by gently prying the top of the cover down to release the hooks along the bottom.

Figure 1 Remove the Guide Cover Assembly

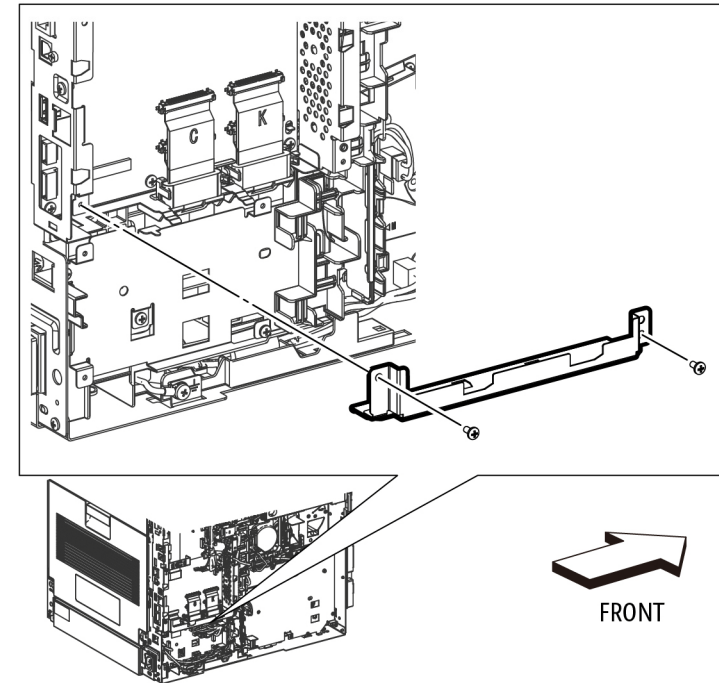
s6510_6515-010

1. Remove the Right Side Cover; REP 19.1.97 (MFP), REP 19.3.97 (SFP).
2. Remove the Left Side Cover; REP 19.2.1 (MFP), REP 19.4.1 (SFP).
3. Remove the Drum Cartridges Y,M,C,K, REP 8.1.1.
4. Remove the Transfer Belt Unit, REP 6.1.1.
5. Remove the LPH Color Head Assembly, REP 2.1.1.
6. Remove the ESS Top Plate, REP 18.1.18.
7. Refer to Figure 1 to remove two screws (silver, M3x6mm) attaching the ESS Lower Plate and remove the plate.

Figure 1 Remove the ESS Lower Plate

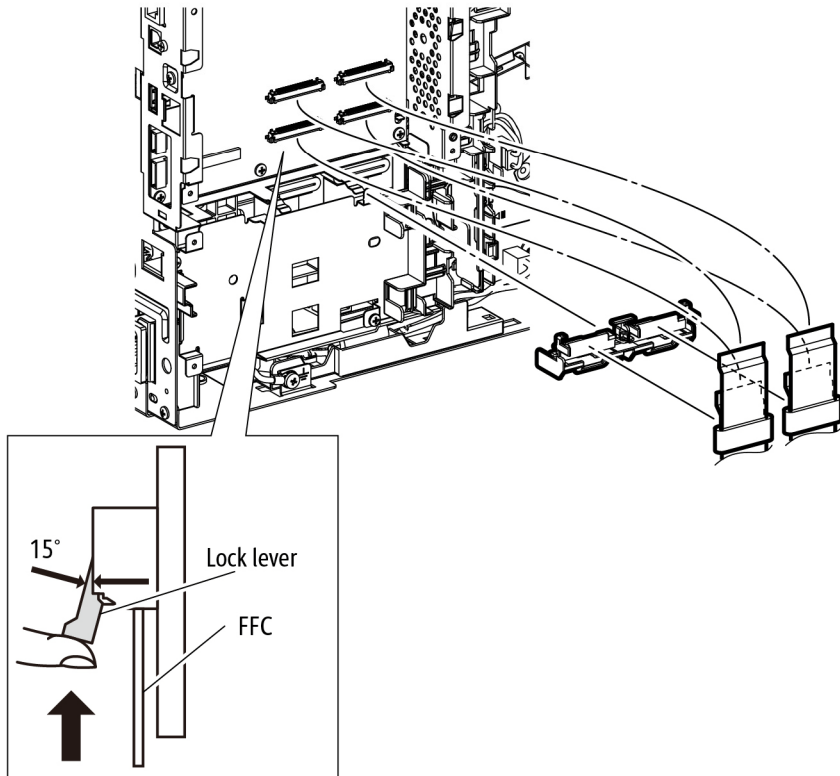
s6510_6515-011

NOTE: In the following step, when releasing the FFC lock lever on the connector, slightly open the lock lever to 15 degrees until the lock lever contacts the FFC connector as shown in Figure 2. After releasing the lock lever, hold the lever while gently pulling the FFC from the connector.

Figure 2 Remove the LPH Color FFC Guide

11. Refer to Figure 2 to remove the LPH Color FFC Guide.
12. Refer to Figure 3 to remove the four LPH Ferrite Cores, by first pressing the reinforcing tabs flat against the FFC.

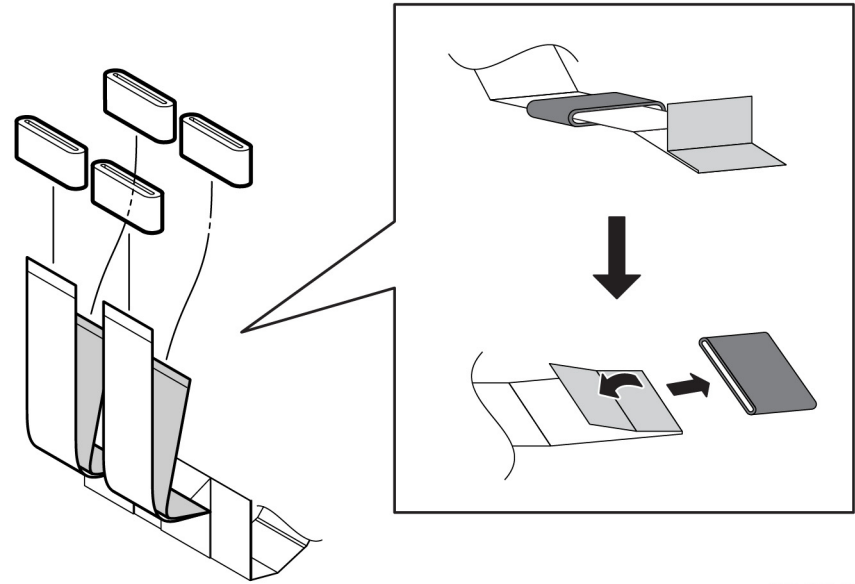
s6510_6515-012

Figure 3 Remove the LPH Ferrite Cores

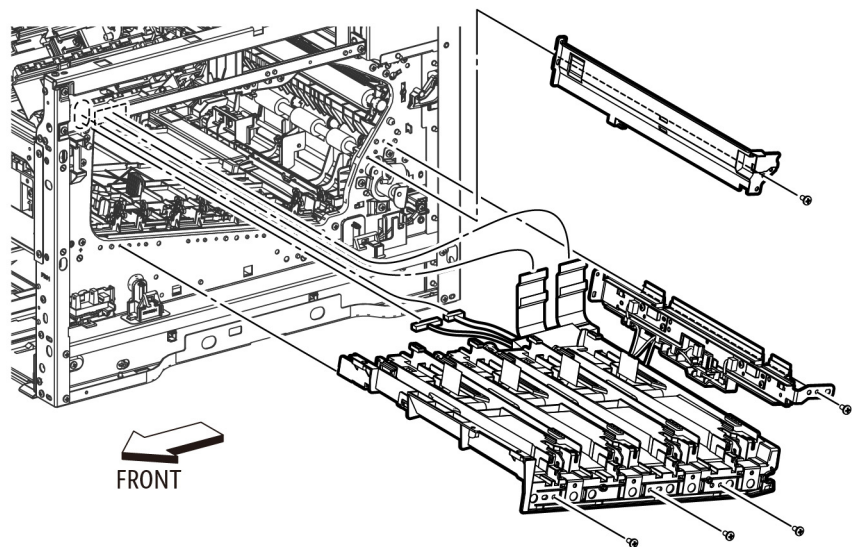
13. Refer to Figure 4 to remove the screw (silver, M3X6mm) attaching the CTD Sensor Cover and remove the cover.

Figure 4 Remove the CTD Sensor Cover, Sensor, and LPH FFC Xerographic CRUM

14. Remove the CTD Sensor Assembly and the LPH Xerographic CRUM FFC:
 - a. Refer to Figure 4 to remove the four screws (silver, M3X6mm) attaching the CTD Sensor Assembly and the LPH Xerographic CRUM FFC.
 - b. Pull the CRUM FFC out about one-third of the way, then feed the four FFC harnesses out through the chassis.
 - c. Feed the remaining two CRUM FFC wire harnesses out through the chassis.
 - d. Remove the CTD Sensor and the CRUM FFC.
15. Refer to Figure 5 to unplug the three connectors (P/J142, P/J143, P/J145) from the CRUM FFC (connecting to the CTD Sensor).

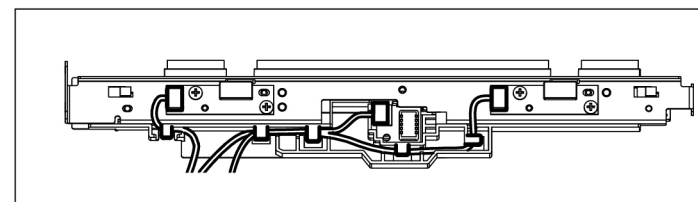
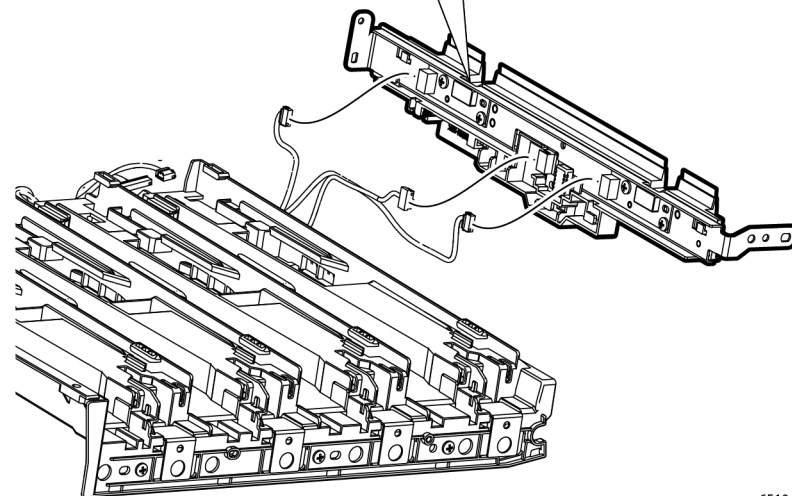
Figure 5 Unplug the CTD Sensor Connectors

16. Refer to Figure 5 to release the cables from the hooks and remove the CTD Sensor from the LPH Xerographic CRUM FFC.

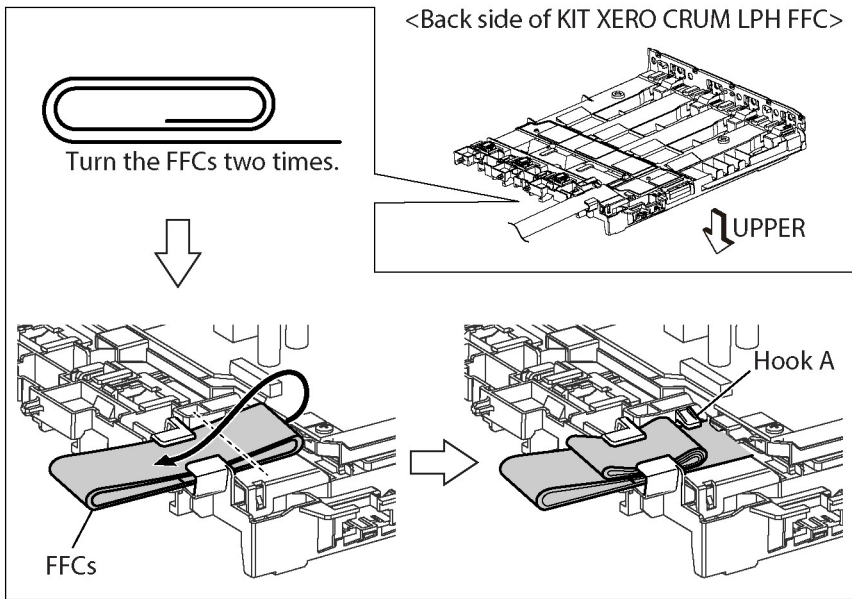
- When installing the LPH Xerographic CRUM FFC, arrange the FFCs as shown in Figure 6.

Figure 6 Fold the FFCs and Install the LPH Xerographic CRUM

- When setting the FFCs, be careful not to catch the turned FFCs at the Hook A shown in Figure 6.
- When folding and connecting the FFCs, arrange the FFCs as shown in Figure 7.

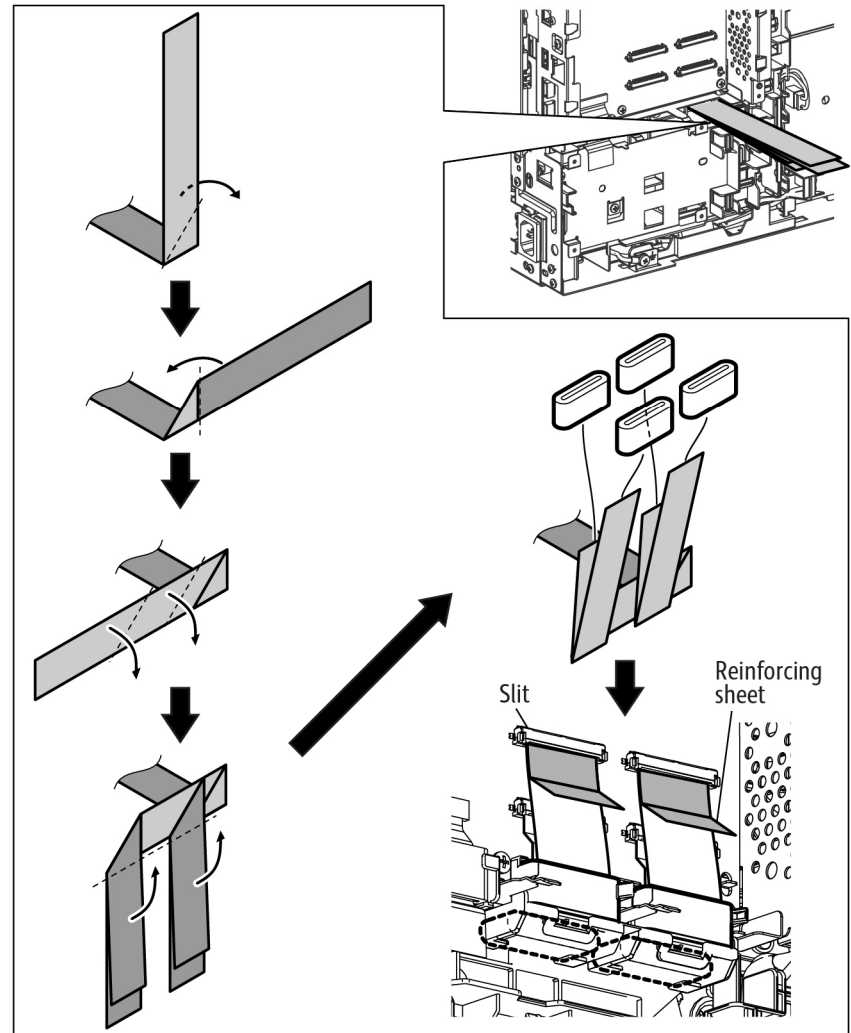
s6510_6515-016

Figure 7 Fold and Connect the FFCs

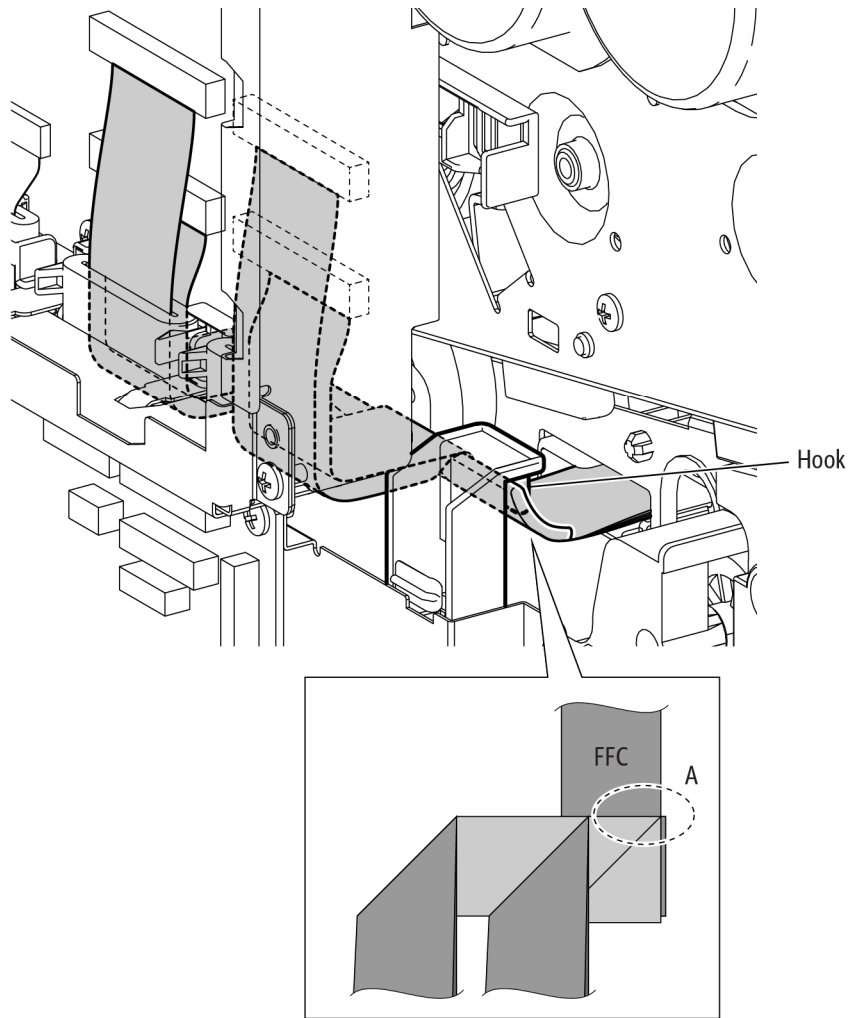
s6510_6515-017

- Before inserting the FFC into the connector, bend the reinforcing tab to 90 degrees as shown in the figure; then, hold the tab to insert the FFC into the slit until hearing a click.
- When installing the FFC, check that the portion A of the FFC is arranged at the hook shown in Figure 8. If not, the FFC may be damaged by coming in contact with neighboring parts.

Figure 8 Position FFC to Avoid Damage

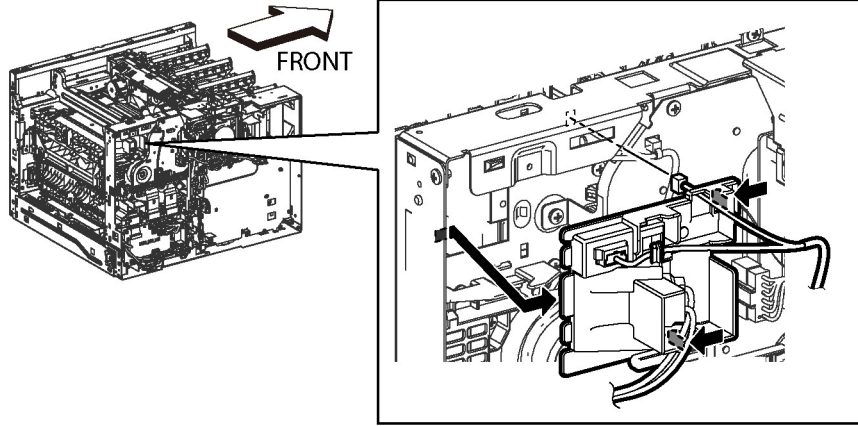
s6510_6515-101

9. Refer to Figure 1 to unplug the connectors P/J272, P/J273 and remove the Fuser harness from the guide.

Figure 1 Remove the Fuser Harness Guide

10. Refer to Figure 1 to release the two hooks attaching the Fuser Harness Guide.
11. Remove the Main Fan, REP 4.1.1.
12. Remove the Main Fan Duct, REP 4.1.2.
13. Remove the MCU Plate; REP 18.1.21 (MFP), REP 18.5.21 (SFP).
14. Refer to Figure 2 to release the harness from the four hooks on the harness guide.

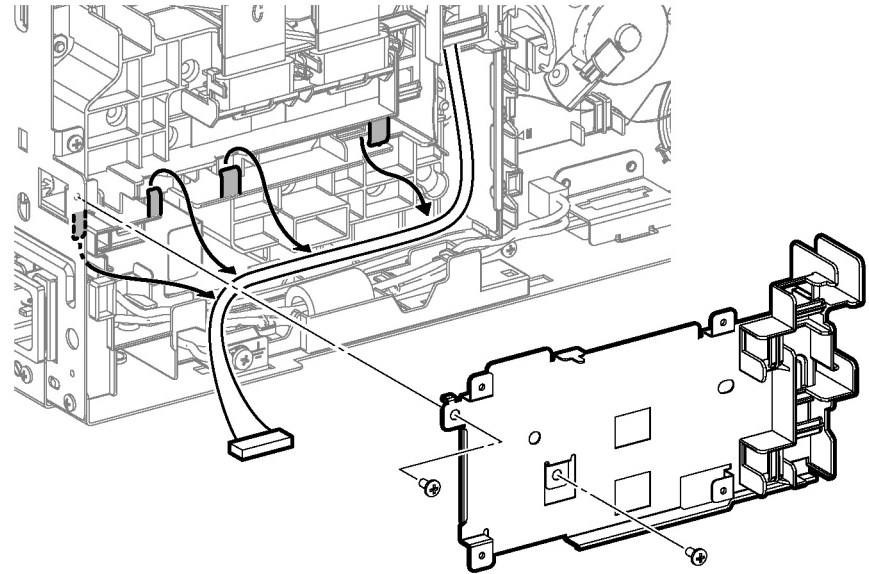
s6510_6515-102

Figure 2 Release Harness Behind the MCU Plate

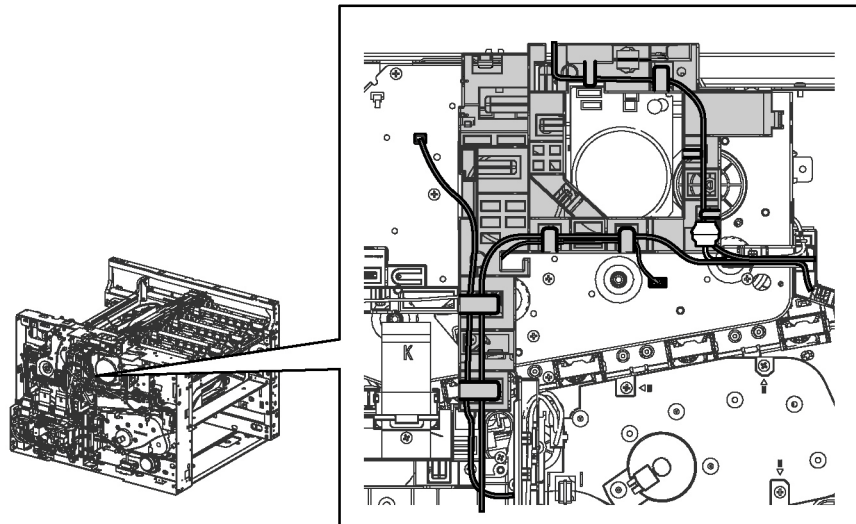
15. Refer to Figure 3 to unplug connectors and release the cables.

Figure 3 Unplug Connectors and Release the Cables

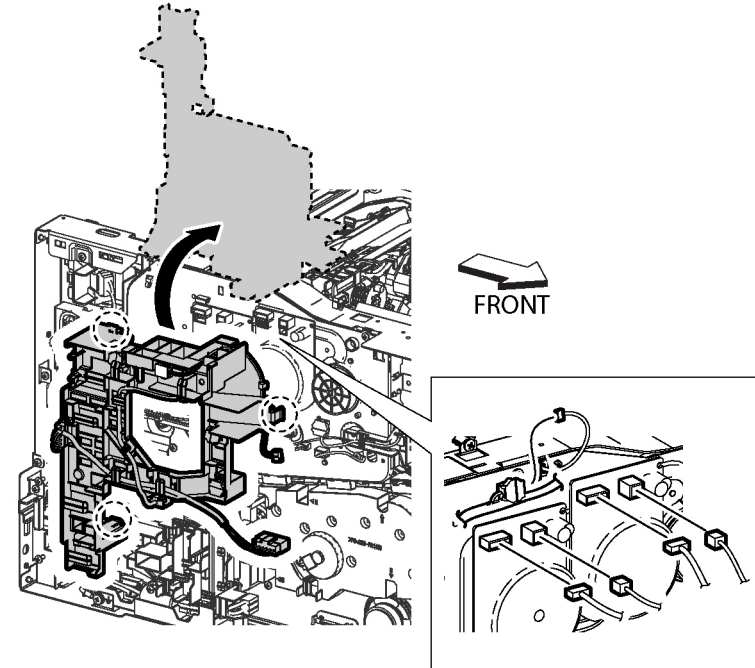
16. Referring to Figure 4 showing the DC Harness Guide, do the following:
 - a. Unplug connector P/J464.
 - b. Release the three hooks of the DC Harness Guide and rotate the guide up onto the top of the printer frame.

Figure 4 Remove the DC Harness Guide

17. Refer to Figure 4 to unplug the five connectors from the Main Drive (P/J571, P/J572, P/J573, P/J 574, P/J464).
18. Refer to Figure 5 to release the cable from the Duct Harness Guide.

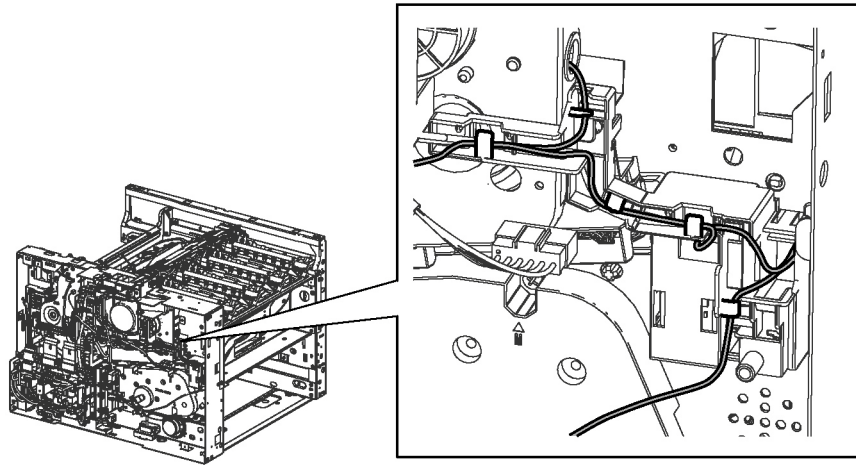
s6510_6515-105

Figure 5 Release Cable from the Duct Harness Guide

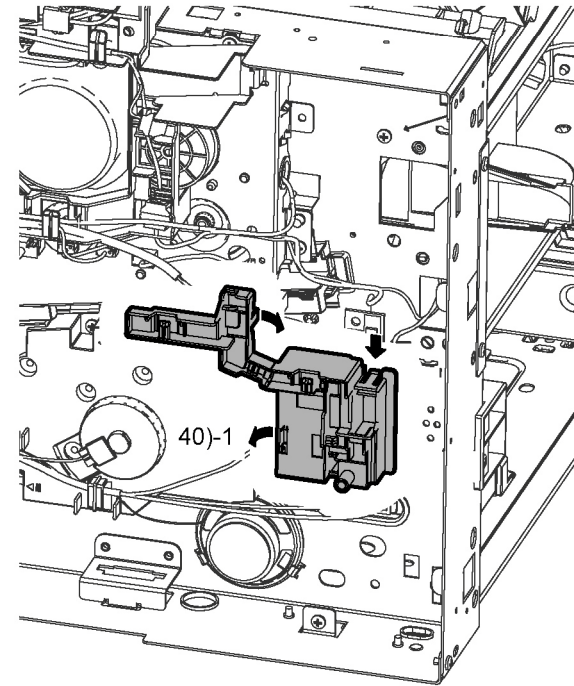
s6510_6515-106

Figure 6 Remove the Duct Harness Guide

19. Refer to Figure 6 to release three hooks on the Duct Harness Guide and remove the guide.

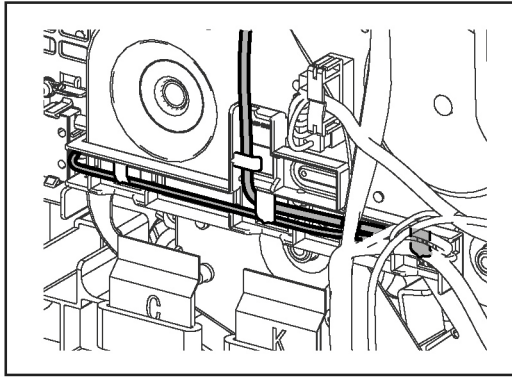
s6510_6515-107

20. Refer to Figure 7 to release the harness from the Interlock Harness Guide.

Figure 7 Release Cable from the Interlock Harness Guide

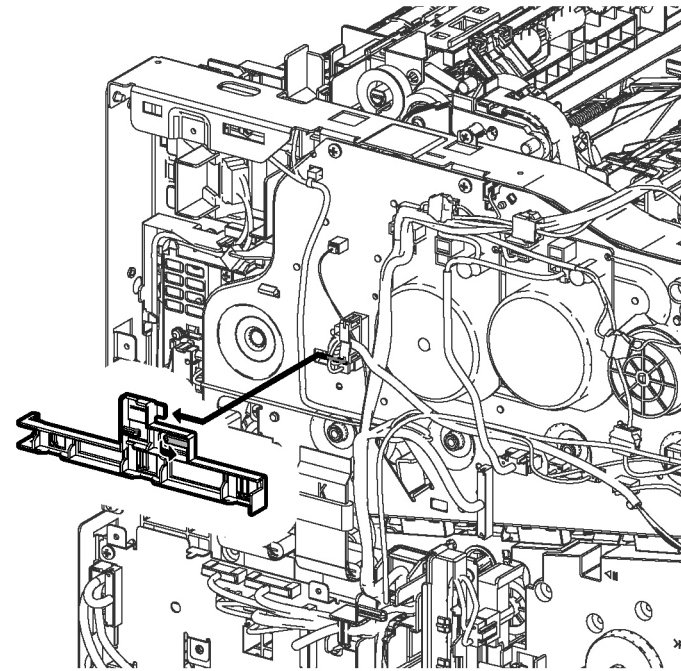
s6510_6515-108

21. Refer to Figure 8 to release the boss on the Interlock Harness Guide and remove the guide.

Figure 8 Remove the Interlock Harness Guide

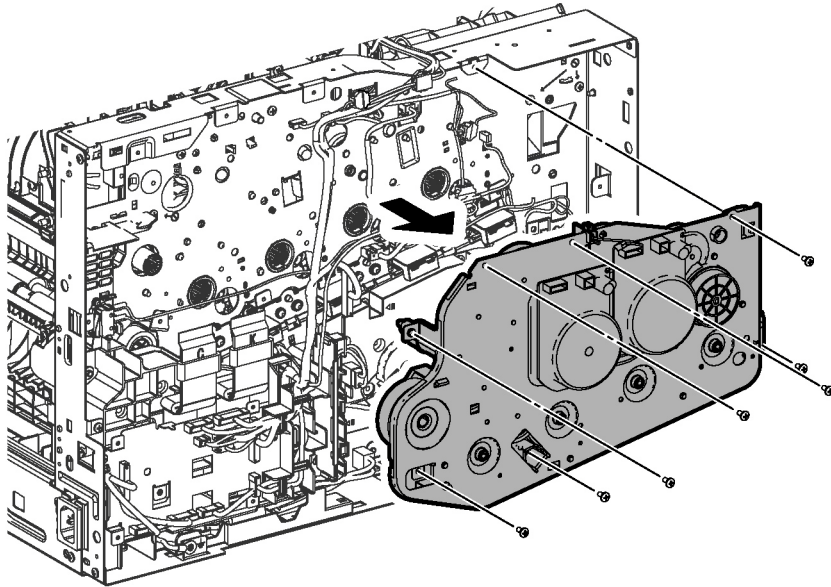
s6510_6515-109

23. Refer to Figure 9 to remove the seven screws (silver, M3x6mm) attaching the Main Drive Assembly and remove the assembly.

Figure 9 Remove the Main Drive Assembly

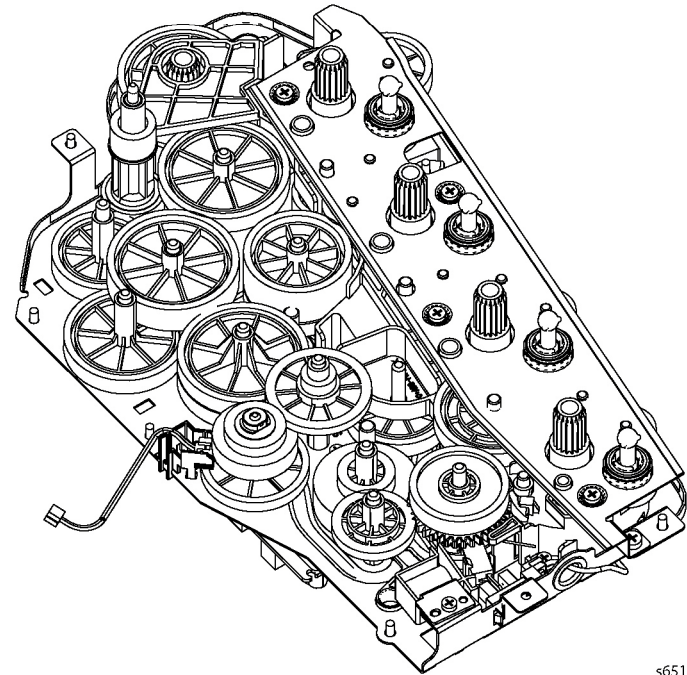
s6510_6515-110

NOTE: Figure 10 shows how the gears are installed on the Main Drive Assembly.

NOTE: When placing the Main Drive Assembly on the workbench, face the gear side upward to prevent the gears from falling off.

Figure 10 Gear Locations on the Main Drive Assembly

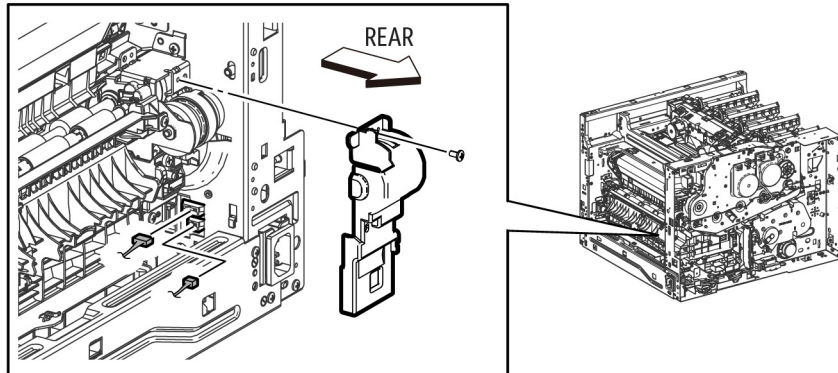
s6510_6515-018

1. Remove the Left Side Cover; REP 19.2.1 (MFP), REP 19.4.1 (SFP).
2. Remove the Rear Cover; REP 19.2.99 (MFP), REP 19.4.99 (SFP).
3. Remove the MCU Board; REP 18.1.1 (MFP); REP 18.5.1 (SFP).
4. Remove the MCU Plate; REP 18.1.21 (MFP), REP 18.5.21 (SFP).
5. Remove the Wireless Module; REP 18.1.11.
6. Remove the FAX Board; REP 18.1.9 (MFP only).
7. Remove the ESS MCU FFC; REP 18.1.2 (MFP), REP 18.5.2 (SFP).
8. Remove ESS Board and Box; REP 18.1.19 (MFP), REP 18.5.19 (SFP).
9. Remove the LVPS Board; REP 18.1.16 (MFP), REP 18.5.16 (SFP).
10. Remove the LVPS Plate; REP 18.1.20 (MFP), REP 18.5.20 (SFP).
11. Refer to Figure 1 to remove the one screw (silver, M3x6mm) from the Duplex Gear Cover and remove the cover.

Figure 1 Remove the MCU Harness Guide and Duplex Gear Cover

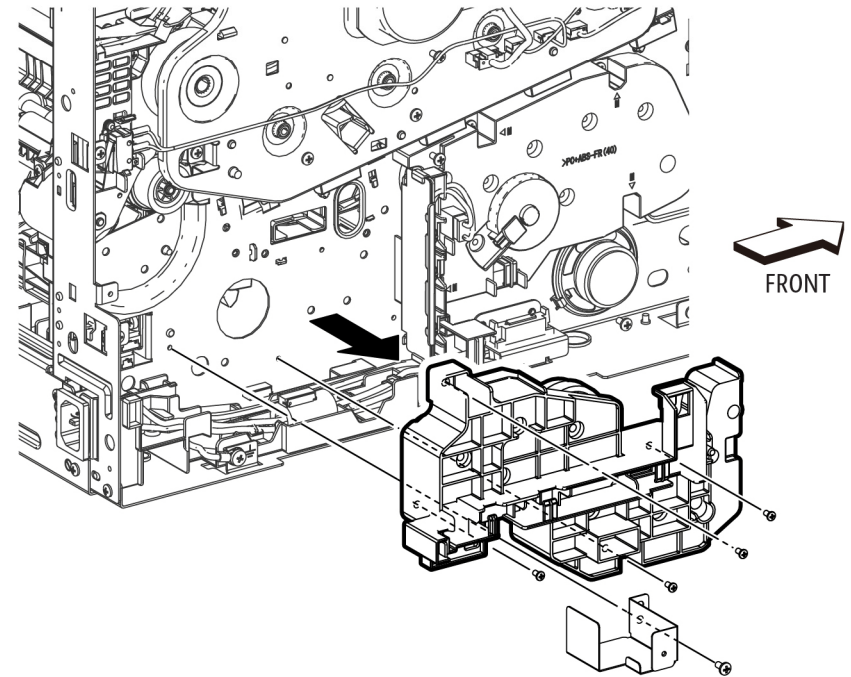
s6510_6515-019

12. Refer to Figure 1 to unplug connectors (P/J541,P/J544) and release the cable from the cable guide.
13. Refer to Figure 2 to remove the one screw (silver, M3x6mm) and remove the Bracket as shown.

Figure 2 Remove the MCU Plate, Bracket, and PH Drive Assembly

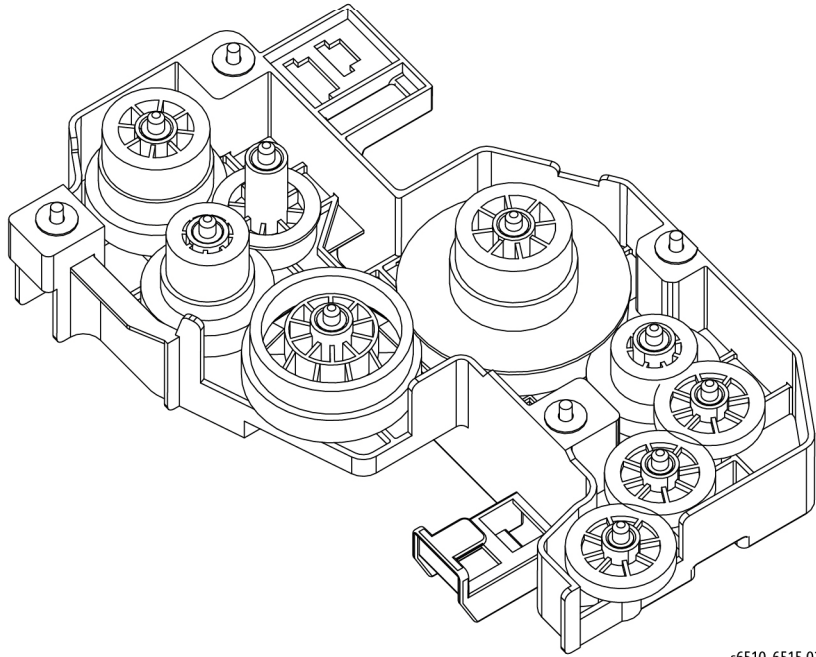
s6510_6515-020

NOTE: When placing the PH Drive Assembly on the workbench, face the gear side upward to prevent the gears from falling off.

Figure 3 Gear Locations on the PH Drive Assembly

NOTE: Figure 3 shows how the gears are installed on the PH Drive Assembly.

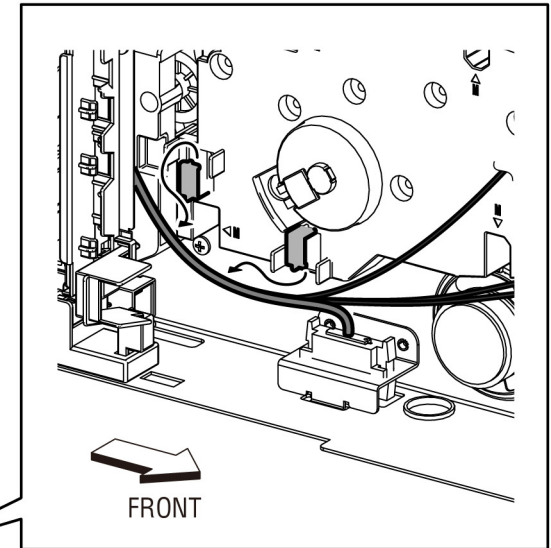
s6510_6515-021

1. Remove the Left Side Cover; REP 19.2.1 (MFP), REP 19.4.1 (SFP).
2. Remove the LVPS Board; REP 18.1.16 (MFP), REP 18.5.16 (SFP).
3. Remove the LVPS Plate; REP 18.1.20 (MFP), REP 18.5.20 (SFP).
4. Refer to Figure 1 to release the harnesses from the Harness guides of the MSI Drive Assembly.

Figure 1 Release the MSI Drive Harnesses

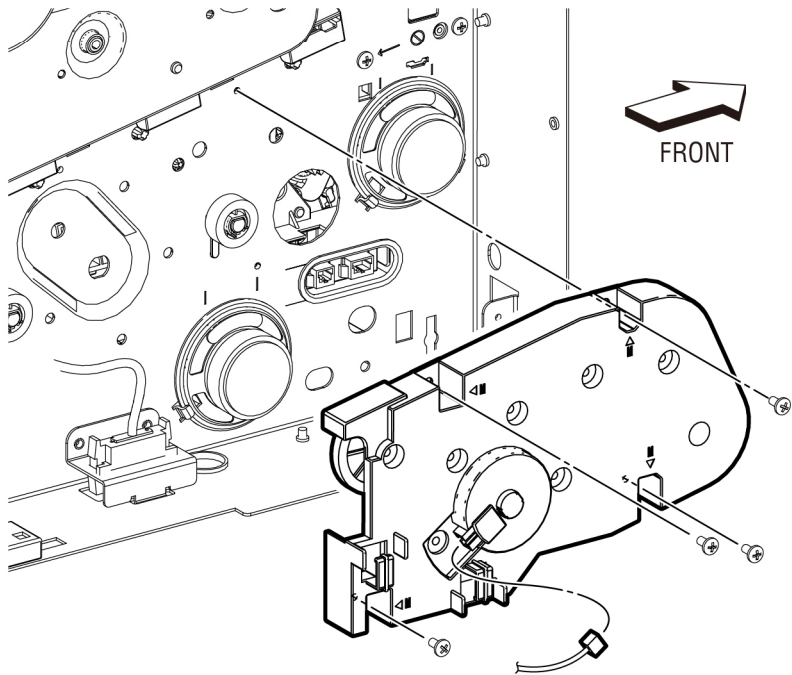
s6510_6515-022

5. Refer to Figure 2 to unplug the connector (P/J481) as shown.

Figure 2 Remove the MSI Drive

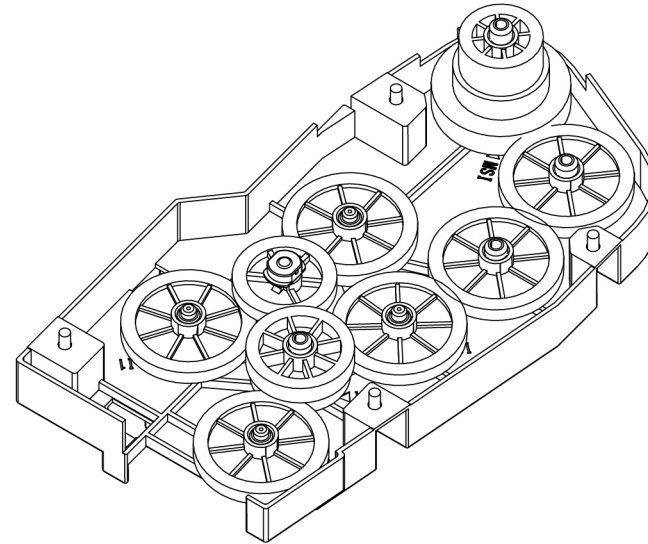
s6510_6515-023

NOTE: When placing the MSI Drive Assembly on the workbench, face the gear side upward to prevent the gears from falling off.

Figure 3 Gear Locations on the MSI Drive Assembly

NOTE: Figure 3 shows how the gears are installed on the MSI Drive Assembly.

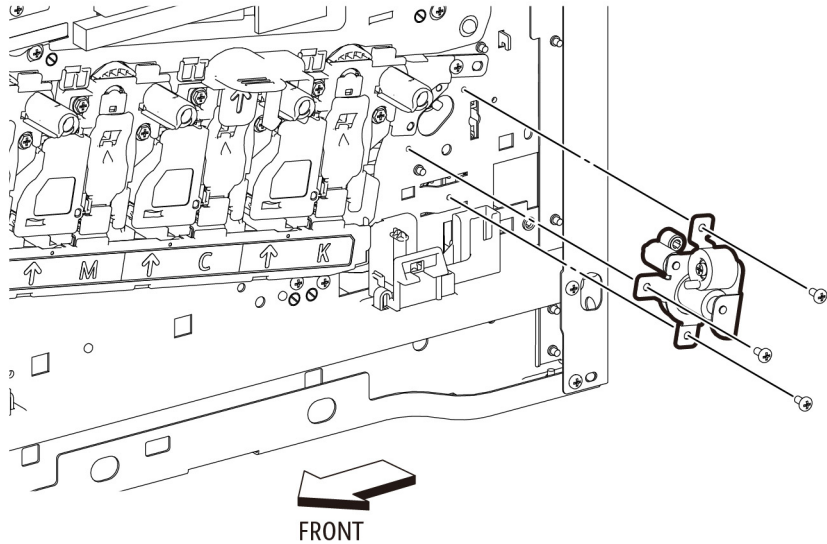
s6510_6515-024

1. Remove the Right Side Cover; REP 19.1.97 (MFP), REP 19.3.97 (SFP).
2. Refer to Figure 1 to remove the three screws (silver, M3X6mm) attaching the Waste Drive and remove the drive.

Figure 1 Remove the Waste Drive Assembly

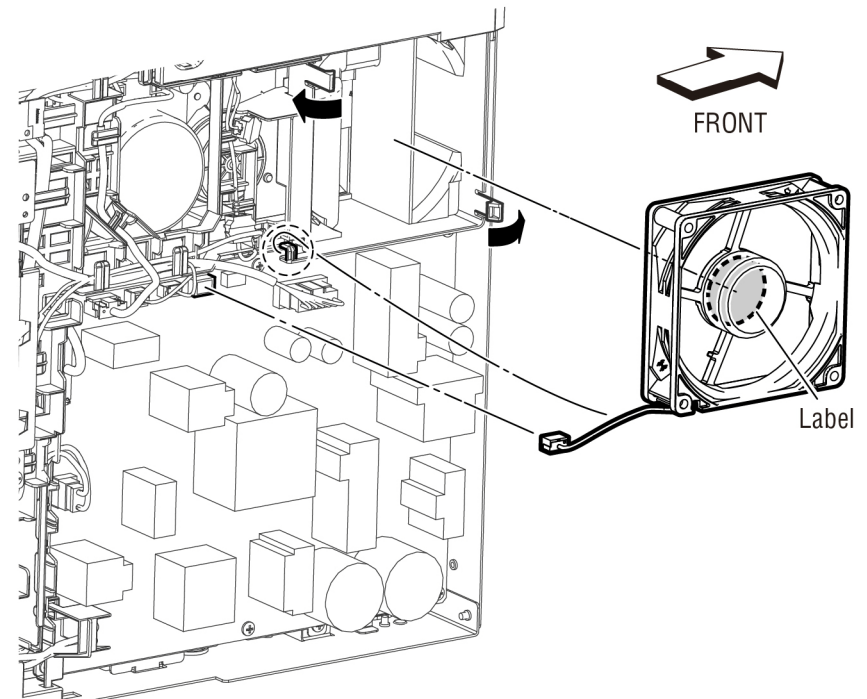
s6510_6515-025

1. Remove the Left Side Cover; REP 19.2.1 (MFP), REP 19.4.1 (SFP).
2. Refer to Figure 1 to unplug connector (P/J289) to the fan.

Figure 1 Remove the Main Fan

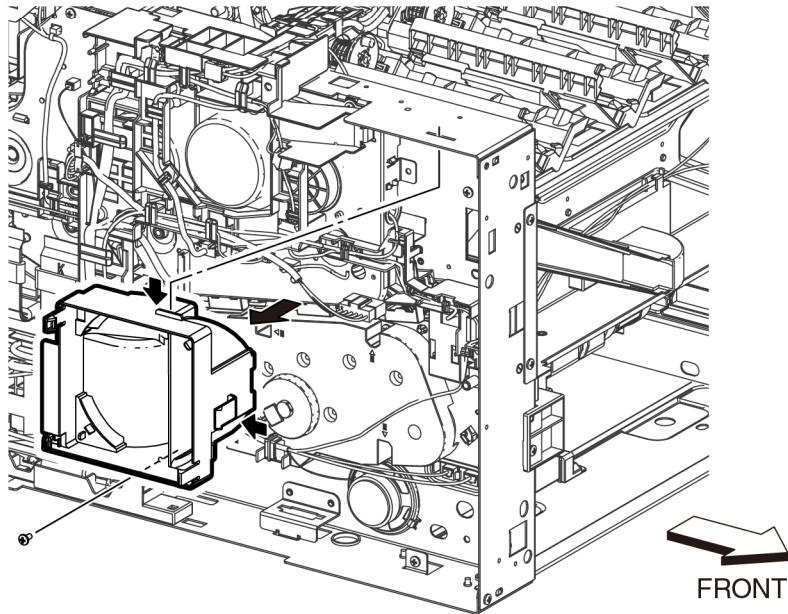
s6510_6515-026

1. Remove the Left Side Cover; REP 19.2.1 (MFP), REP 19.4.1 (SFP).
2. Remove the Main Fan, REP 4.1.1.
3. Remove the screws from the LVPS Board and Plate to expose the screw attaching the Main Fan Duct shown in Figure 1. If you are removing only the Main Fan Duct, it is not necessary to remove the LVPS Board or Plate.

Figure 1 Remove the Main Fan Duct

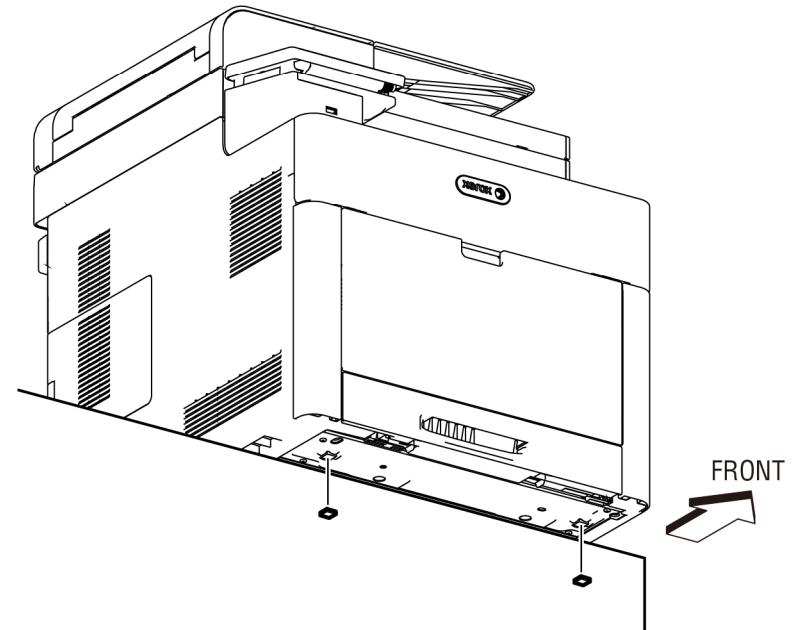
s6510_6515-027

1. Position the front of the printer to overhang the edge of the workbench.
2. Refer to Figure 1 to replace the front two feet.

Figure 1 Replace the Front Bottom Feet

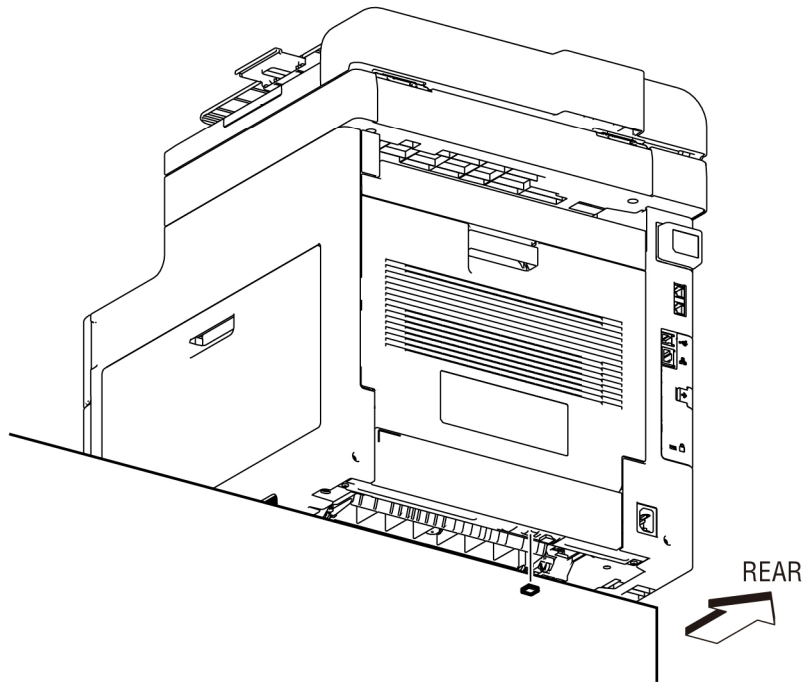
s6510_6515-028

Figure 2 Replace the Rear Bottom Foot

3. Position the back of the printer to overhang the edge of the workbench.
4. Refer to Figure 2 to replace the back foot.

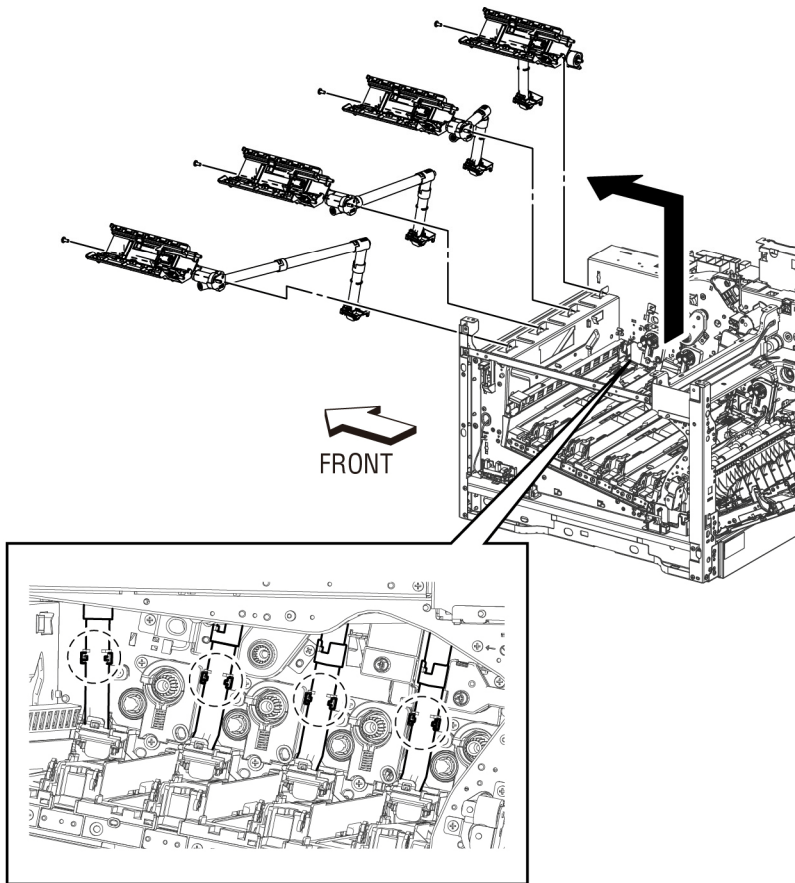
s6510_6515-029

1. Remove the 250 Sheet Cassette.
2. Remove the Main Bypass Tray, REP 13.2.1.
3. Remove the Drum Cartridge, REP 8.1.1., corresponding to the dispenser being replaced.
4. Remove the Transfer Belt Unit, REP 6.1.1.
5. Remove the Top Cover Assembly; REP 19.1.99 (MFP), REP 19.3.99 (SFP).
6. Remove the Main Exit Drive Assembly, REP 17.1.4.
7. Remove the Dispenser Drive Assembly, REP 5.1.99, except skip step 4 by leaving P/J121, P/J122 connected.
8. Refer to Figure 1 to remove the two screws that attach the RH Brace (supporting the Dispenser Drive Assembly), then rotate the Dispenser Drive Assembly up to the left.

Figure 1 Remove the Dispenser Assemblies

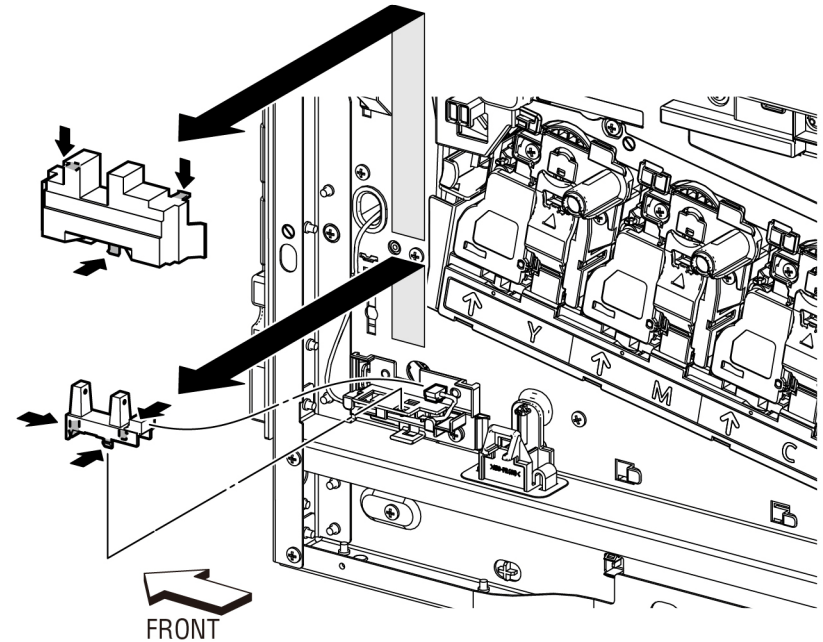
s6510_6515-030

1. Remove the Right Side Cover; REP 19.1.97 (MFP), REP 19.3.97 (SFP).
2. Refer to Figure 1 to release the three hooks on the Clear Cover starting with the bottom hook and remove the cover.

Figure 1 Remove the Toner Full Sensor

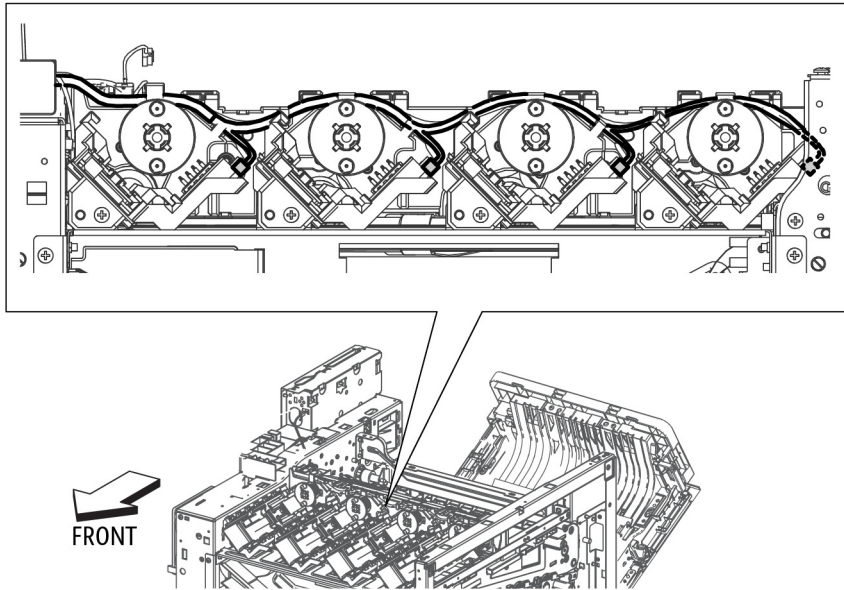
1. Remove all four of the Toner Cartridges.
2. Remove the Top Cover Assembly; REP 19.1.99 (MFP), REP 19.3.99 (SFP).
3. Remove the Main Exit Drive Assembly, REP 17.1.4.
4. Refer to Figure 1 to unplug the four connectors (P/J111, P/J112, P/J113, P/J114) and release the Toner CRUM Harness Assembly.

Figure 1 Release the Toner CRUM Harness Assembly

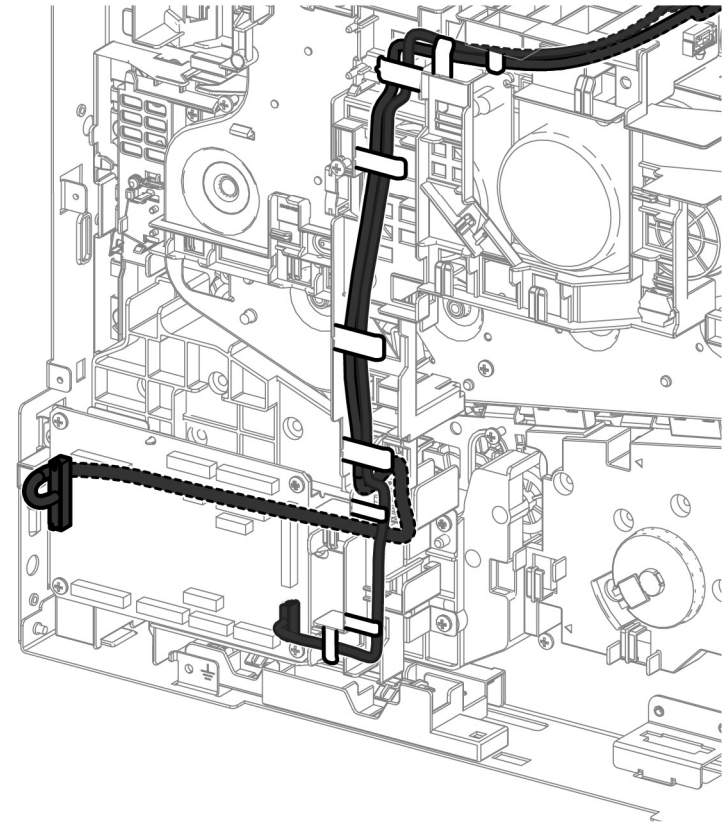
5. Refer to Figure 2 to unplug the two connectors (P/J110, P/J120) from the Dispenser Drive Harness Assembly and release the harnesses from the harness guide.

Figure 2 Release the Dispenser Drive Harnesses

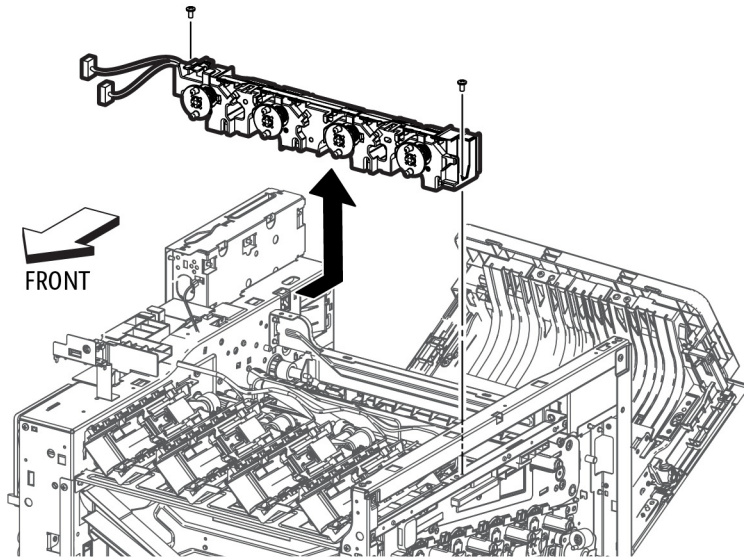
s6510_6515-033

6. Refer to Figure 3 to remove the two screws (silver, M3x6mm) attaching the Dispenser Drive Assembly and remove the drive.

Figure 3 Remove the Dispenser Drive Assembly

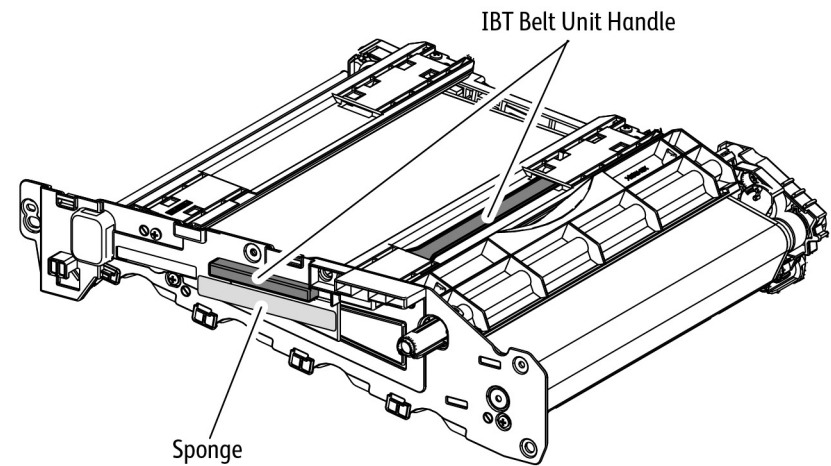
s6510_6515-034

Figure 1 Handle Locations on the Transfer Belt Unit

NOTE: In the following step, do not grasp the foam on Transfer Belt Unit Cover when replacing the Transfer Unit. Grasp the Transfer Belt Unit Handles (see Figure 1).

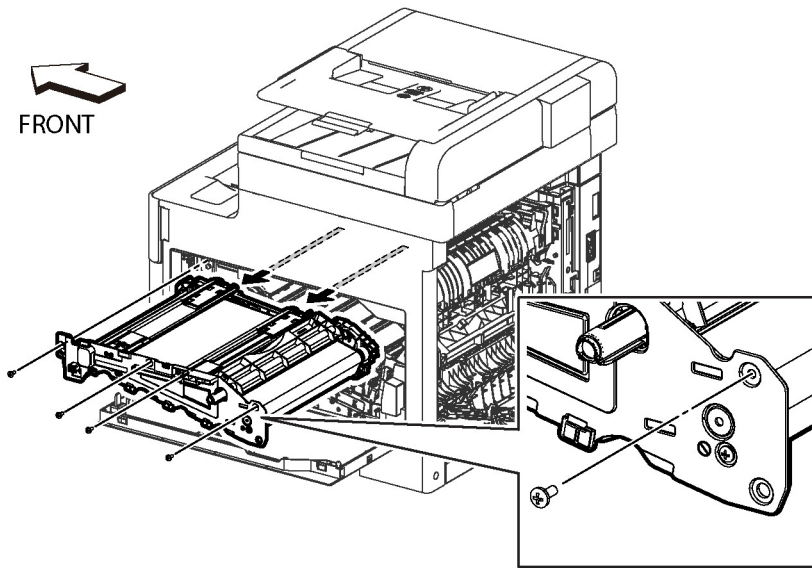
s6510_6515-035

5. Refer to Figure 2 to remove the four screws attaching the Transfer Belt Unit and remove the Transfer Belt Unit from the rails. Remove only the screws seated against the metal frame as shown in the figure.

Figure 2 Remove the Transfer Belt Unit

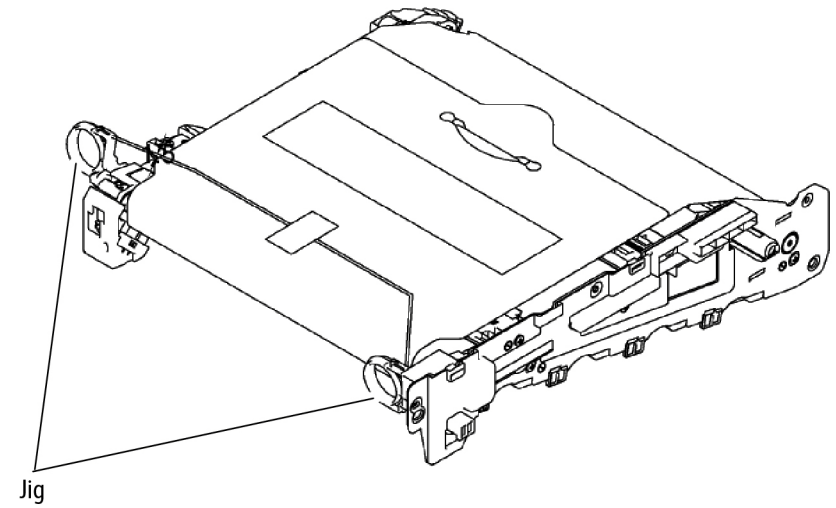
s6510_6515-036

Figure 3 Remove Jigs before Installing a New Transfer Belt Unit

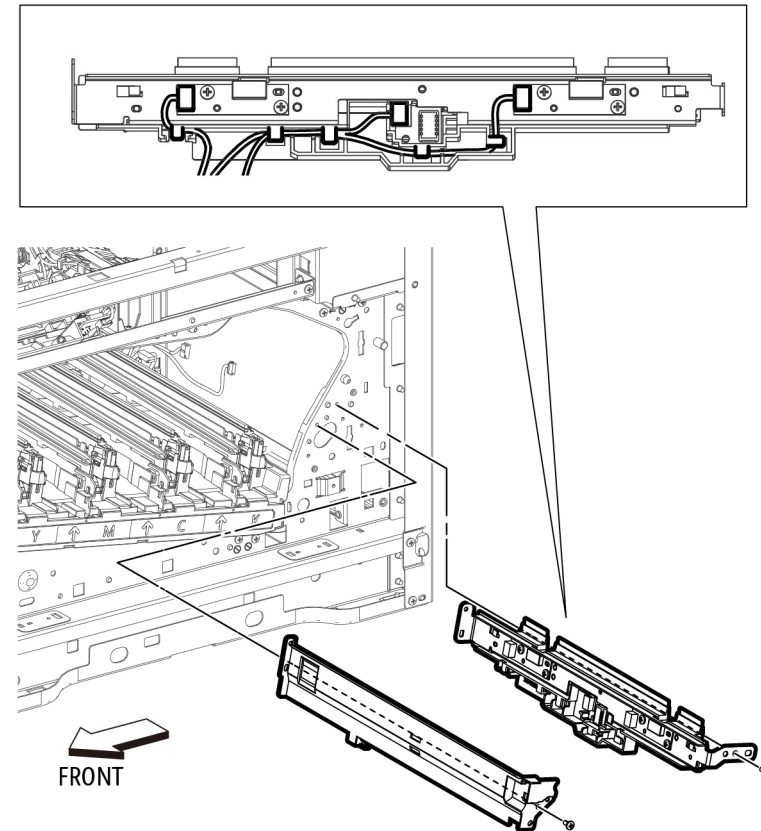
s6510_6515-037

1. Remove the 250 Cassette Assembly.
2. Remove the Right Side Cover, REP 19.1.97.
3. Remove the Drum Cartridges, REP 8.1.1.
4. Remove the Transfer Belt Unit, REP 6.1.1.
5. Remove the Guide Cover Assembly, REP 2.1.11.
6. Remove the Rear Cover; REP 19.2.99 (MFP), REP 19.4.99 (SFP).
7. Remove the Registration Chute Feeder Assembly, REP 15.2.1.
8. Refer to Figure 1 to remove the one screw (silver, M3x6mm) attaching the Sensor Cover and remove the cover.

Figure 1 Remove the CTD Sensor Assembly
