Phaser® 6510, WorkCentre® 6515 Service Manual

Xerox Phaser 6510 Color Printer/WorkCentre 6515 Color Multifunction Printer

Phaser 6510 Color Printer/WorkCentre 6515 Color Multifunction Printer Service Manual

705P01382

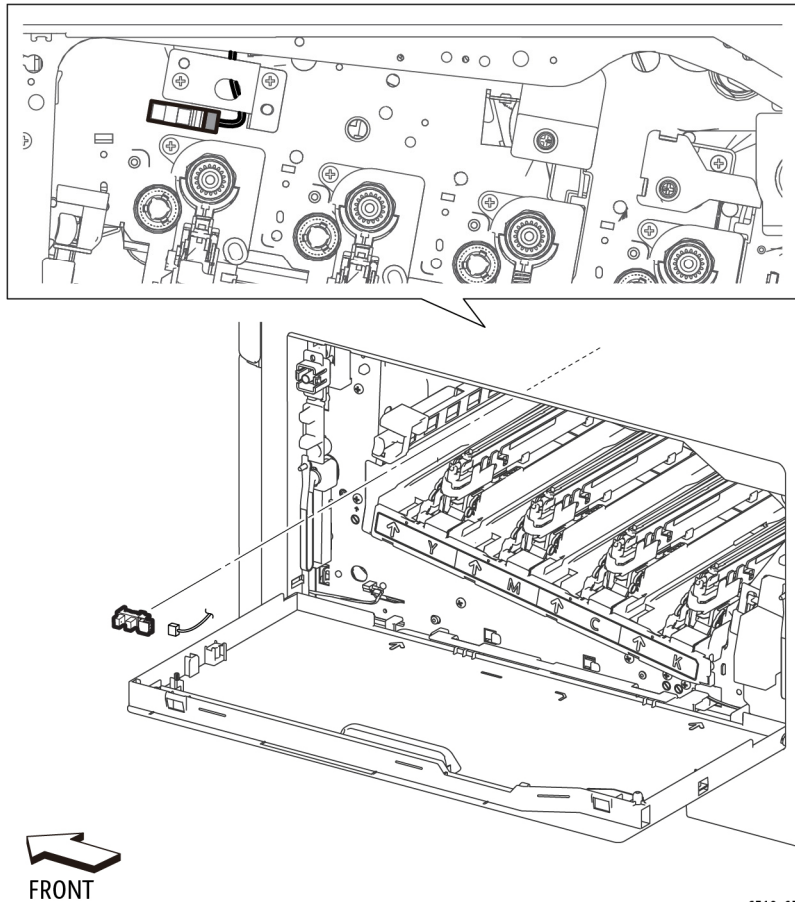
1. Remove the Transfer Belt Unit, REP 6.1.1.
2. Remove the Drum Cartridge, REP 8.1.1.
3. Refer to Figure 1 to remove the Photo Sensor.
4. Unplug the connector (P/J466) from the Photo Sensor.

Figure 1 Remove the Photo Sensor

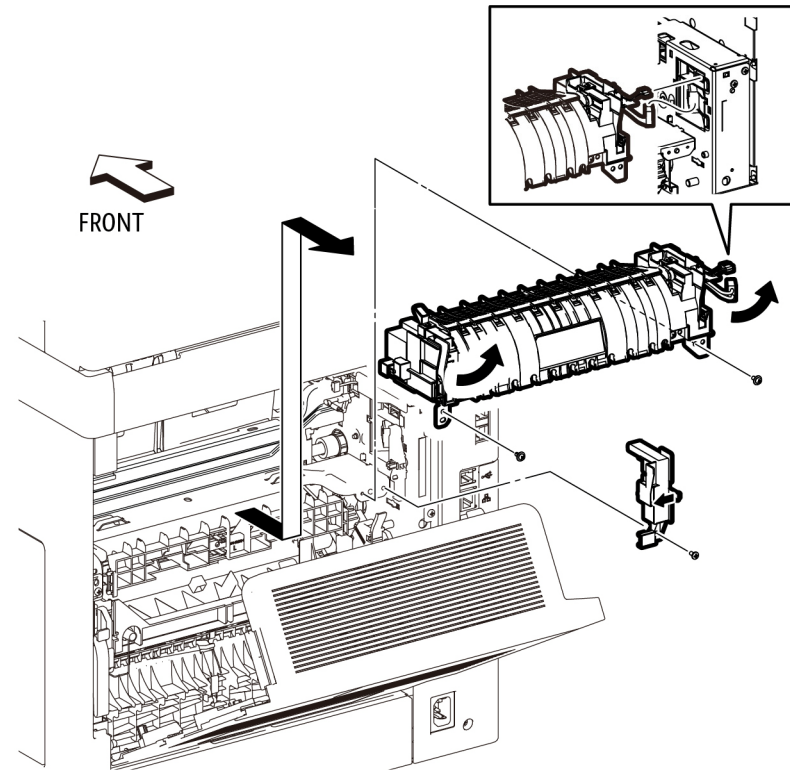
s6510_6515-039

1. Remove the Fuser Harness Cover, REP 7.1.2.
2. Refer to Figure 1 to remove the two screws (silver, M3x8mm with spring washer and flat washer) attaching the Fuser Assembly.

Figure 1 Remove the Fuser

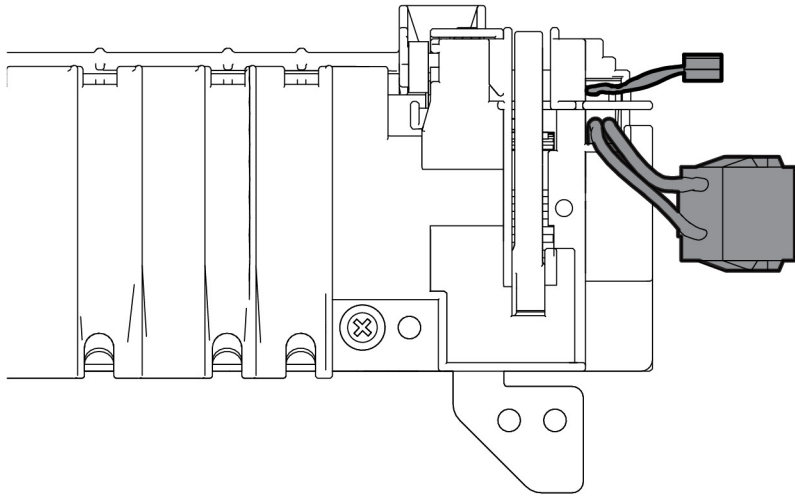
s6510_6515-040

When installing the Fuser Harness Cover, avoid damaging the cable passing through the Fuser housing. Follow the harness routing shown in Figure 2.

Figure 2 Avoid Pinching Wires

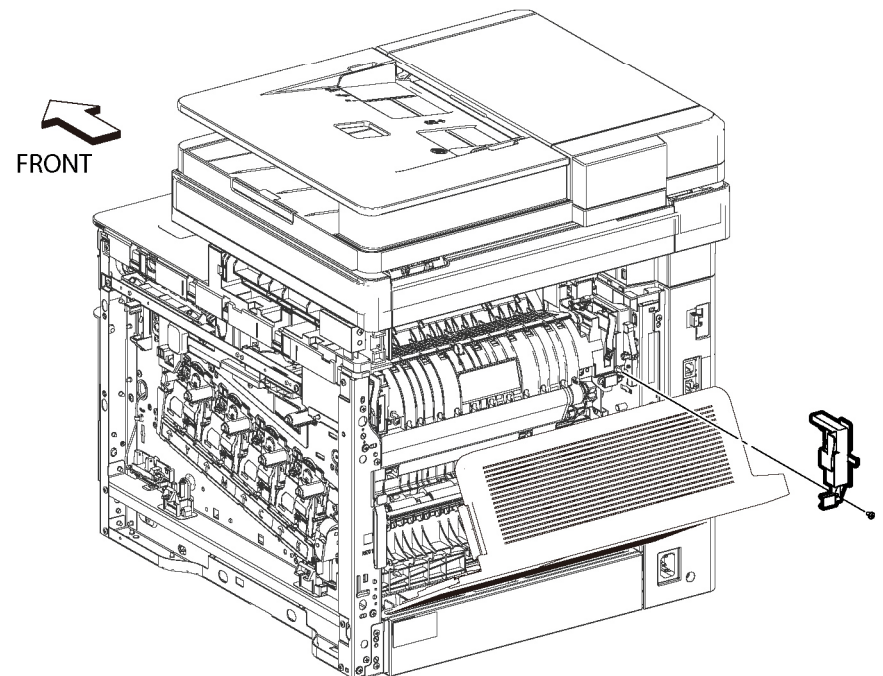
s6510_6515-061

1. Open the Rear Cover.
2. Refer to Figure 1 to remove the one screw (silver, M3x6mm) attaching the lower end of the Fuser Harness Cover to the Fuser Assembly.

Figure 1 Remove the Fuser Harness Cover

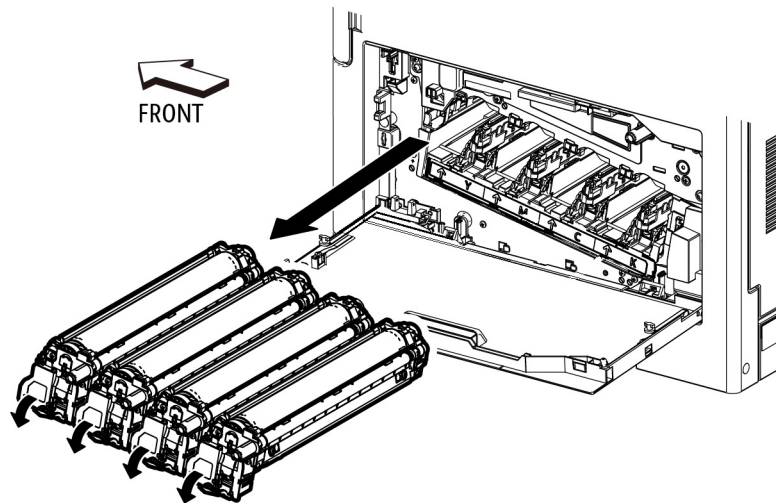
s6510_6515-041b

2. Refer to Figure 1 to release the lever on the Drum Cartridge, then slide the assembly straight out.

Figure 1 Remove the Drum Cartridge

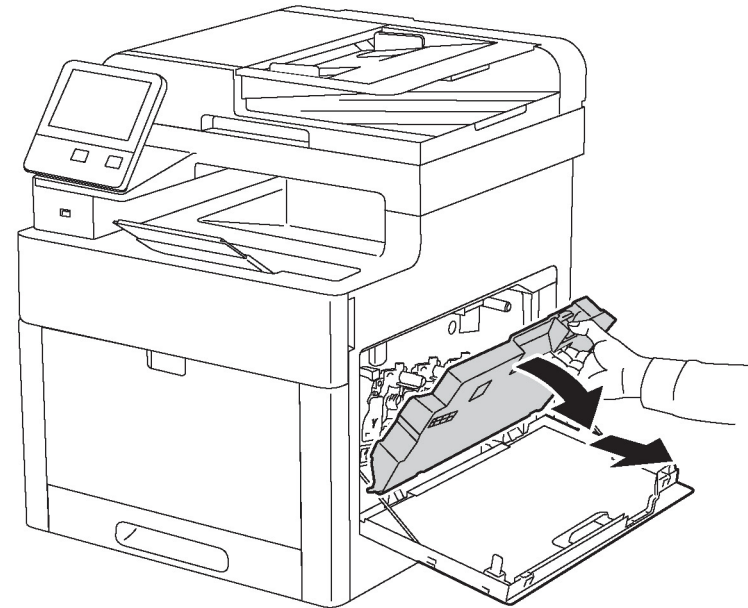
s6510_6515-119

2. Refer to Figure 1 to remove the Waste Cartridge by depressing the tab and pulling the Cartridge out in the direction shown.

Figure 1 Remove the Waste Cartridge

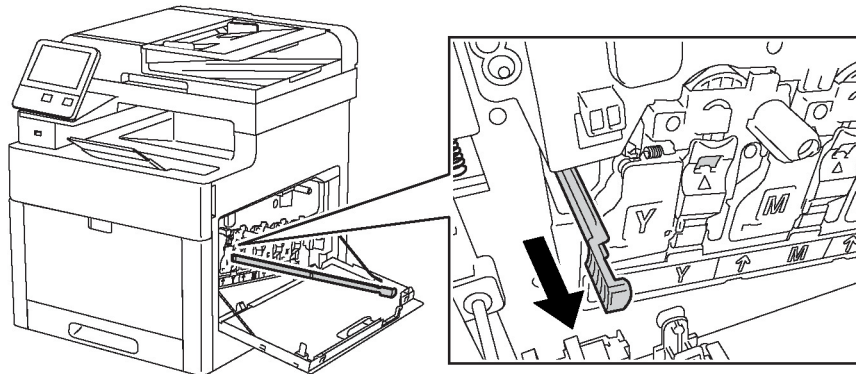
s6510_6515-120

1. Remove the Waste Cartridge, REP 8.1.5.
2. Refer to Figure 1 to pull out the Cleaner Assembly.

Figure 1 Remove the LPH Cleaner Assembly

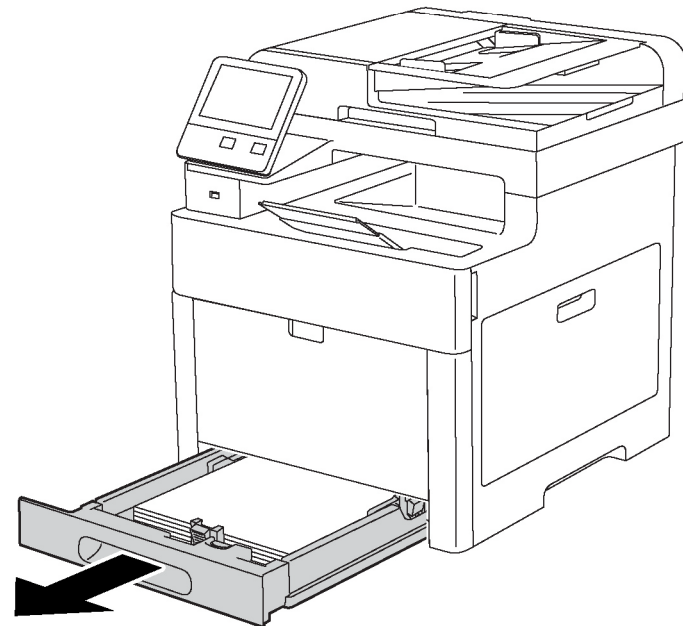
s6510_6515-121

1. Refer to Figure 1 to remove the 250 Cassette Assembly from the printer.

Figure 1 Remove the 250 Cassette Assembly

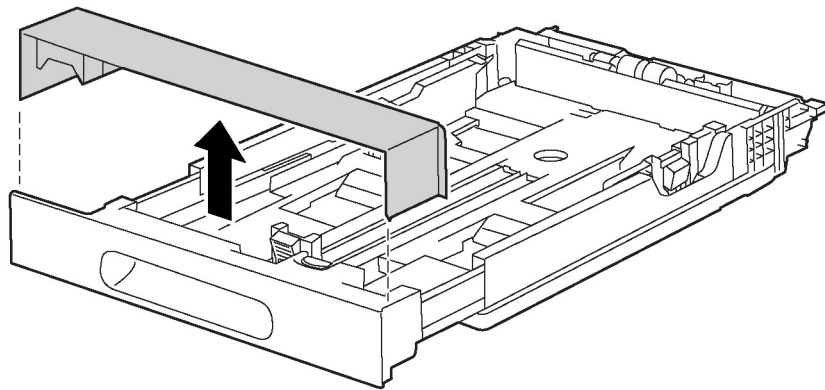
s6510_6515-122

1. Remove the 250 Cassette Assembly from the printer.
2. Refer to Figure 1 to release the latches that hold the Legal Paper Tray Cover to the cassette, and remove the Cover.

Figure 1 Remove the Legal Paper Tray Cover

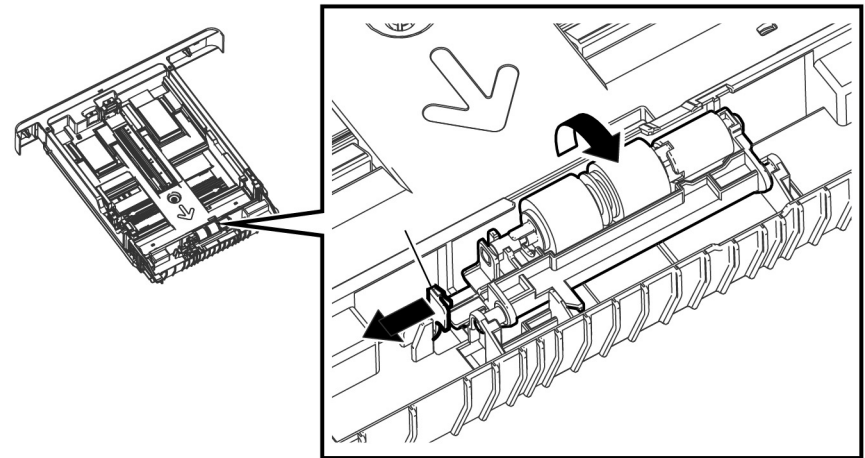
s6510_6515-042

1. Remove the 250 Cassette Assembly from the printer.
2. Refer to Figure 1 to release the hook at the end of the Cassette Separator Holder, then lift the holder in the direction of the arrow.

Figure 1 Release the Cassette Separator Holder Hook

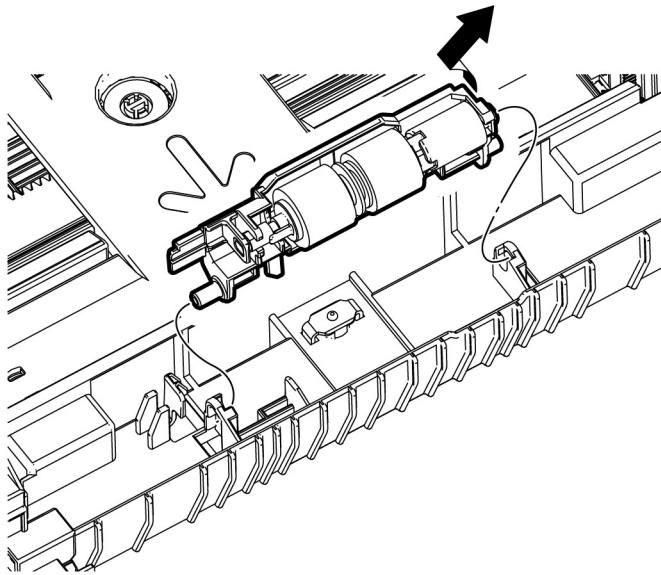
s6510_6515-043

Figure 2 Remove the Cassette Separator Roller Assembly

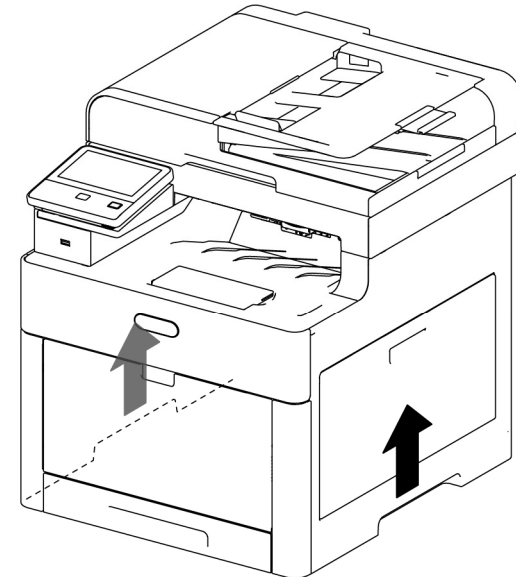
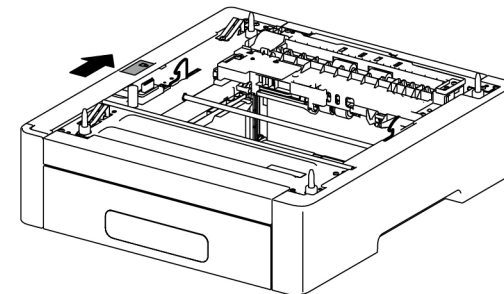
s6510_6515-044

1. Refer to Figure 1 to slide the lever and release the two hooks attaching the 550 Option Feeder Assembly.

Figure 1 Remove the 550 Option Feeder Assembly

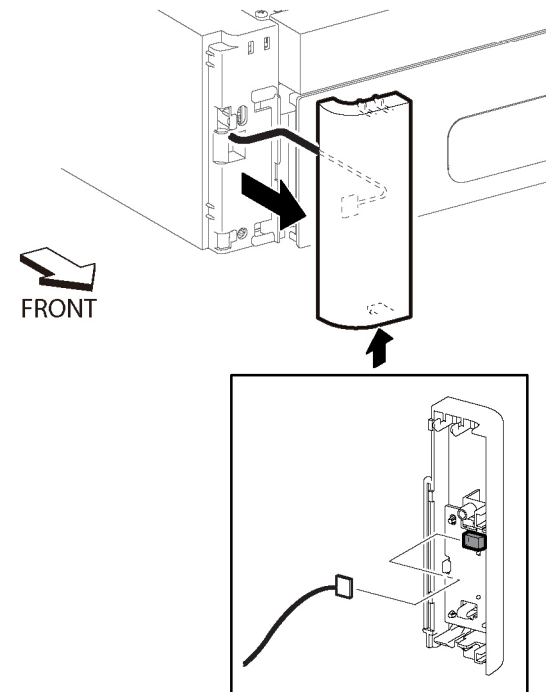
s6510_6515-112

2. Refer to Figure 1 to push the hook at the bottom of the Option Feeder Left Front Cover, and release the cover.

Figure 1 Remove the 550 Option Feeder Left Front Cover

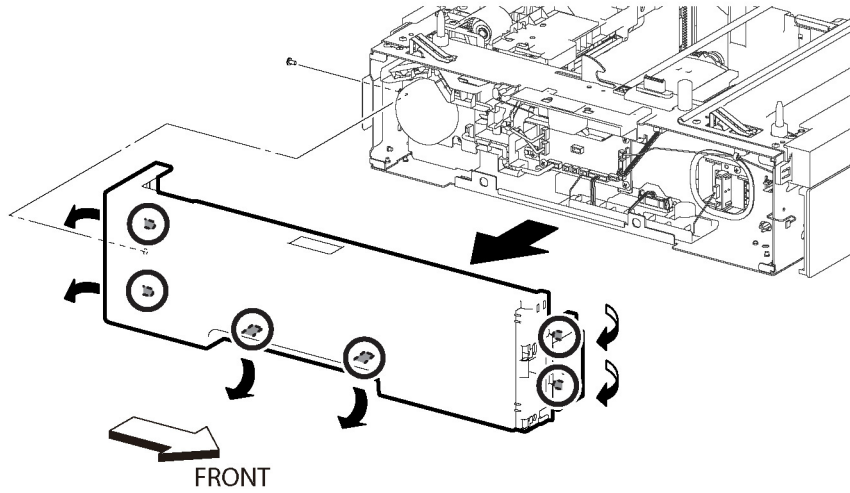
s6510_6515-113

Figure 2 Remove the 550 Option Feeder Left Side Cover

5. Refer to Figure 2 of the Left Side Cover to release, in order, two bosses at the rear side, two hooks at the bottom, and two bosses at the front side.
6. Remove the Left Side Cover from the feeder.

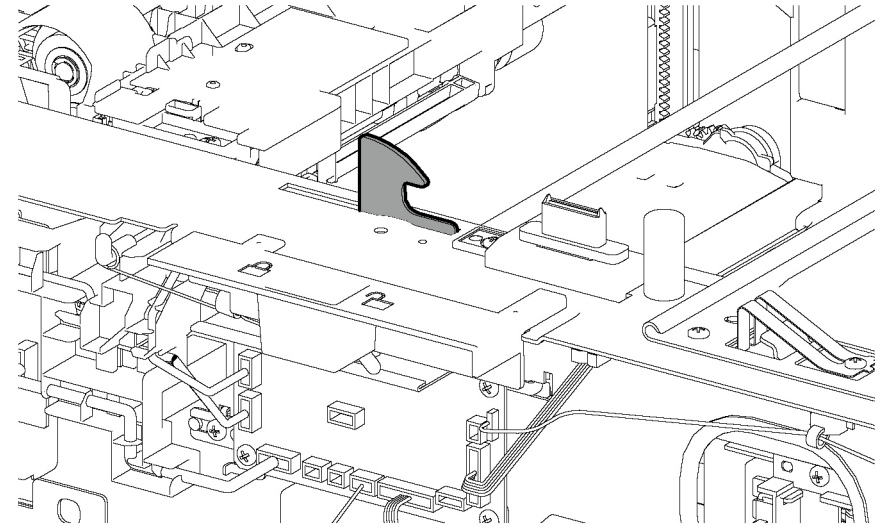
s6510_6515-114

NOTE: Before installing the Option Feeder Left Side Cover, set the Option Feeder Lock Assembly to the lock position as shown in Figure 3.

Figure 3 Place the Option Feeder Lock into Locked Position

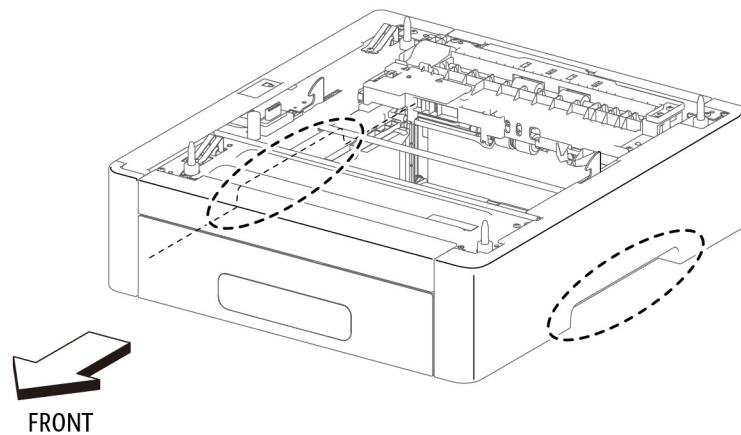
s6510_6515-045

1. Remove the 550 Option Feeder Assembly from the printer, REP 10.1.1.
2. Remove the 550 Option Cassette from the 550 Option Feeder, REP 10.3.1.
3. Refer to Figure 1 for locations to hold the 550 Option Feeder Assembly, then turn over the feeder.

Figure 1 Locations to Hold the 550 Option Feeder

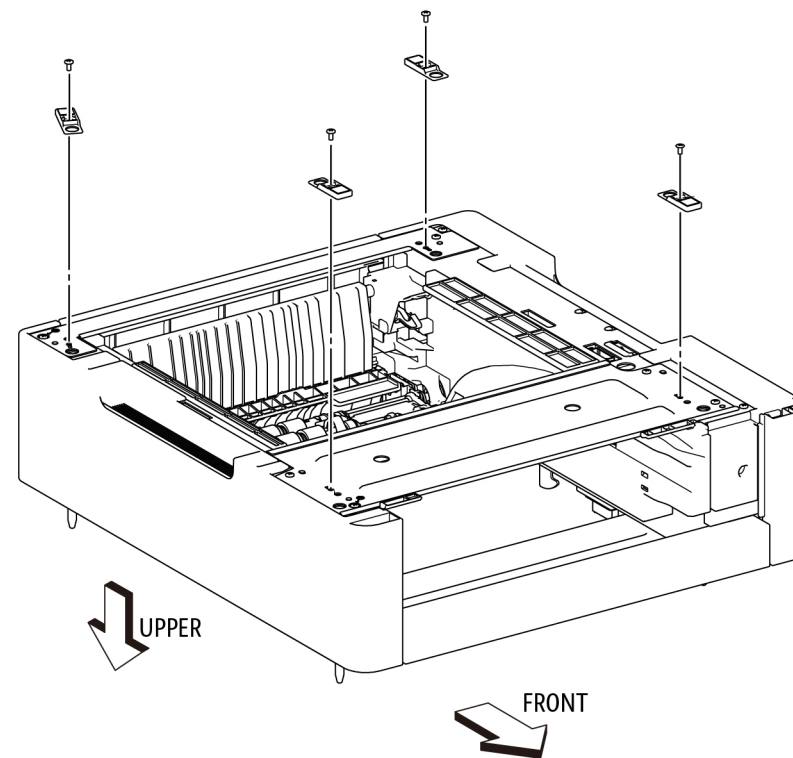
4. Refer to Figure 2 to remove the screw (silver, M3x6mm) attaching each foot to the 550 Option Feeder Assembly.

Figure 2 Remove the 550 Option Feeder Feet

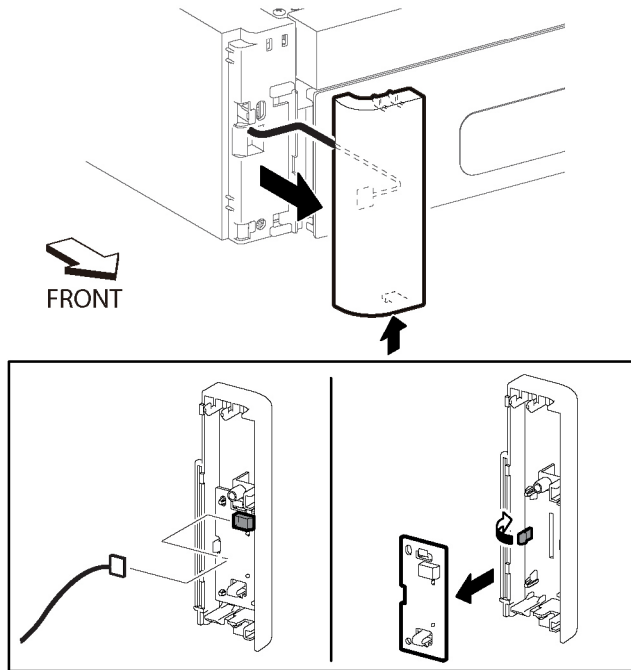
2. Refer to Figure 1 to remove the Option Feeder Left Front Cover.

Figure 1 Remove the 550 Option Feeder Left Front Cover

3. Unplug the connector (P/J814) from the Left Front Cover.
4. Refer to Figure 1 to release the hook and remove the LED Tray Assembly.
5. Remove the 550 Option Feeder Left Side Cover, REP 10.1.2.
6. Refer to Figure 2 to unplug the connector (P/J813), remove two clamps, and remove the LED Harness Assembly.

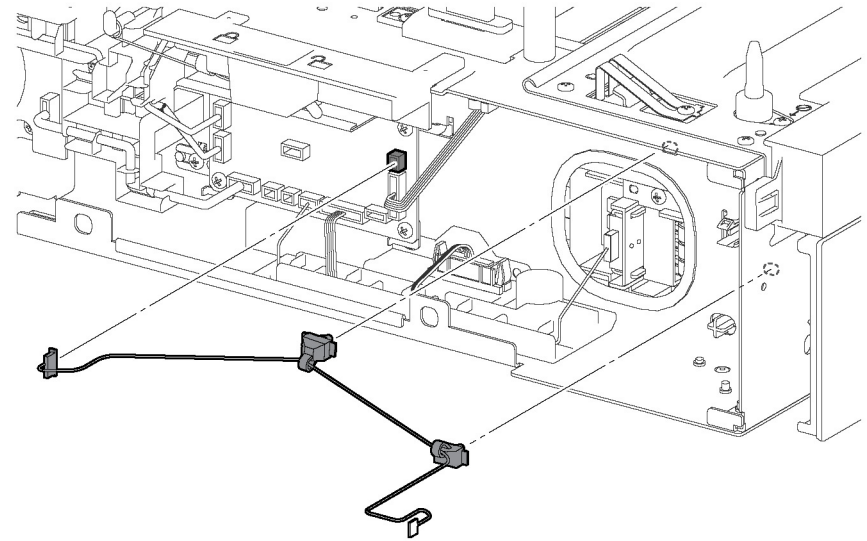
Figure 2 Remove the LED Harness Assembly

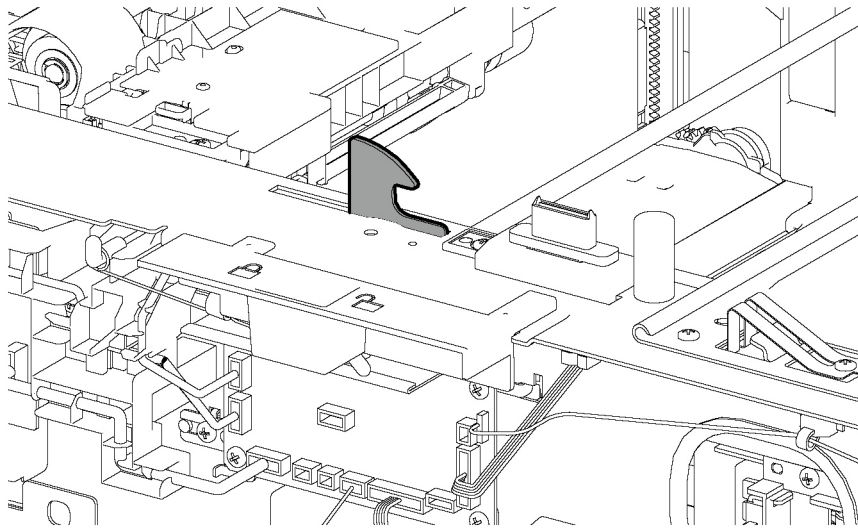
NOTE: Before installing the Option Feeder Left Side Cover, set the Option Feeder Lock Assembly to the lock position as shown in Figure 3.

Figure 3 Place the Option Feeder Lock into Locked Position

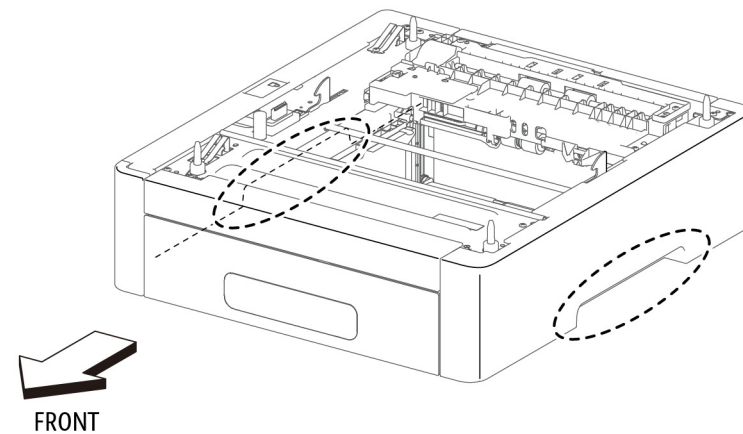
1. Remove the 550 Option Feeder Assembly, REP 10.1.1.
2. Remove the 550 Option Cassette from the 550 Option Feeder, REP 10.3.1.
3. Referring to Figure 1 for locations to hold the 550 Option Feeder Assembly, turn over the feeder.

Figure 1 Locations to Hold the 550 Option Feeder

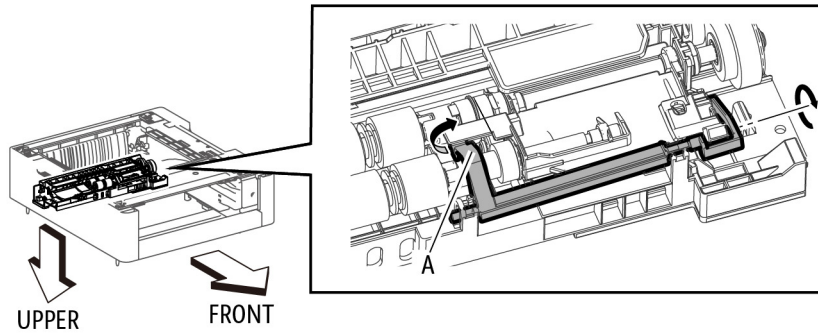
Figure 2 Release the No Paper Actuator

When replacing the No Paper Actuator, make sure to snap portion A shown in Figure 2 back into its original position.

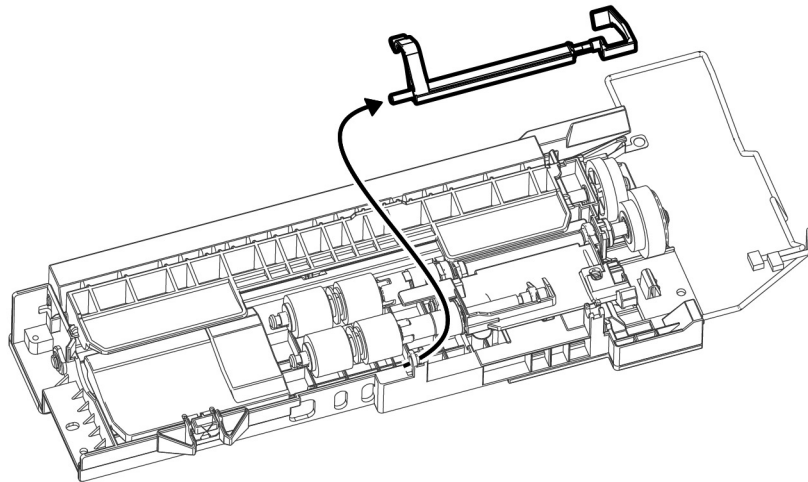
5. Referring to Figure 3, with the No Paper Actuator fully rotated out of its home position, remove the No Paper Actuator.

Figure 3 Remove the No Paper Actuator

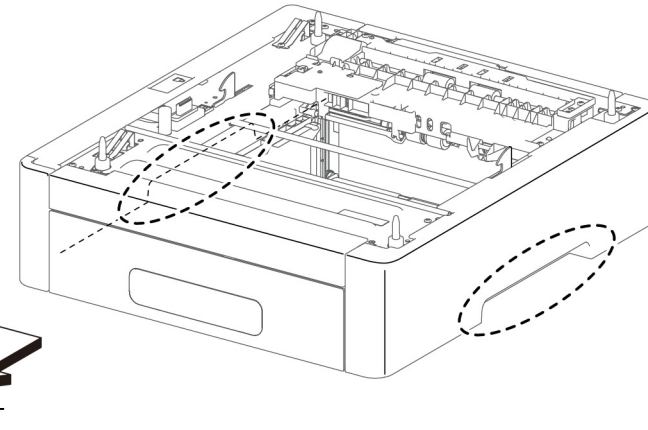
1. Remove the 550 Option Feeder Assembly from the printer, REP 10.1.1.
2. Remove the 550 Option Cassette from the 550 Option Feeder, REP 10.3.1.
3. Referring to Figure 1 for locations to hold the 550 Option Feeder Assembly, turn over the 550 Option Feeder Assembly.

Figure 1 Locations to Hold the 550 Option Feeder

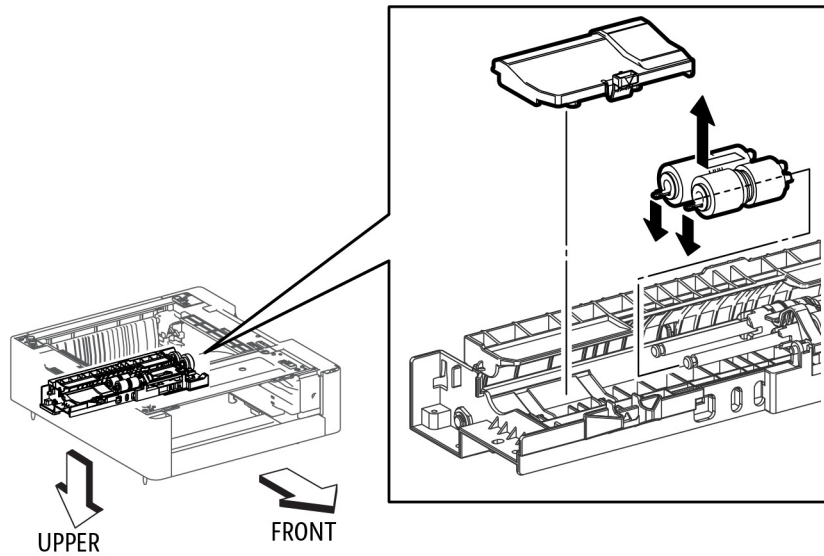
Figure 2 Remove the Feed Roller Assembly

5. Refer to Figure 2 to release the hook and remove the Feed Roller Assembly from the 550 Option Feeder Assembly.

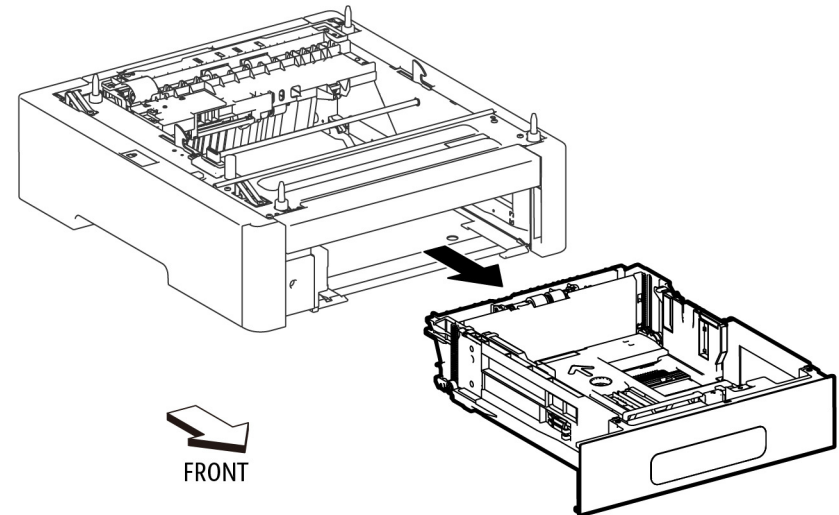
1. Refer to Figure 1 to remove the 550 Option Cassette Assembly from the 550 Option Feeder Assembly.

Figure 1 Remove the 550 Option Cassette Assembly

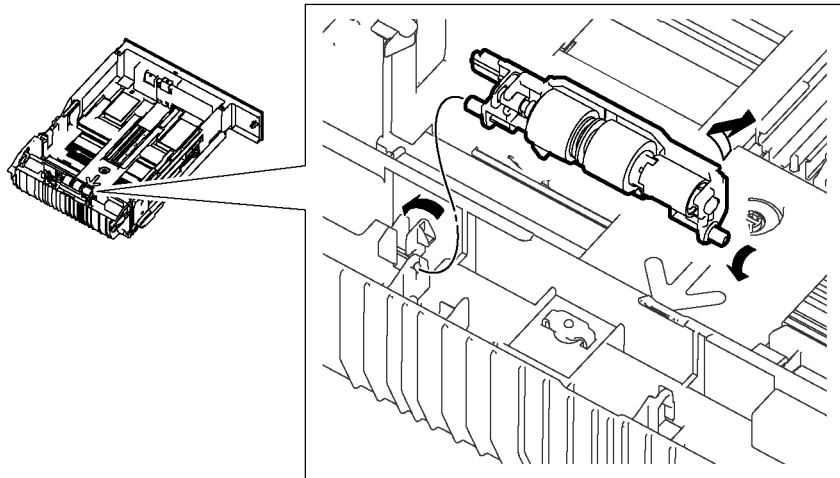
1. Remove the 550 Option Cassette Assembly, REP 10.3.1.
2. Refer to Figure 1 to release the hook on the holder.

Figure 1 Remove the Cassette Separator Holder Assembly

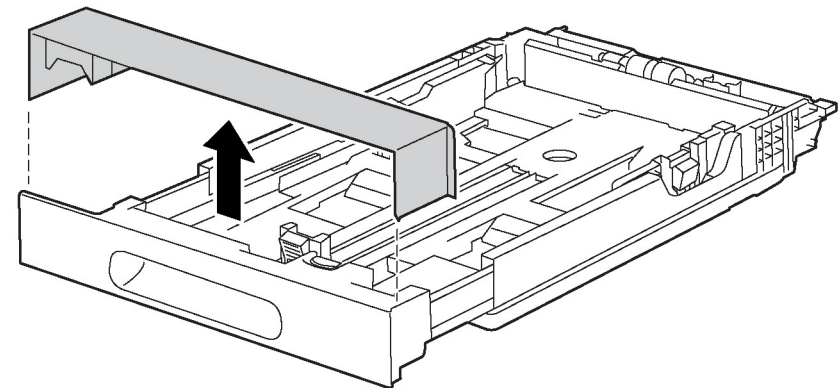
1. Remove the 550 Option Cassette Assembly, REP 10.3.1.
2. Refer to Figure 1 to remove the Legal Paper Tray Cover.

Figure 1 Remove the Legal Paper Tray Cover

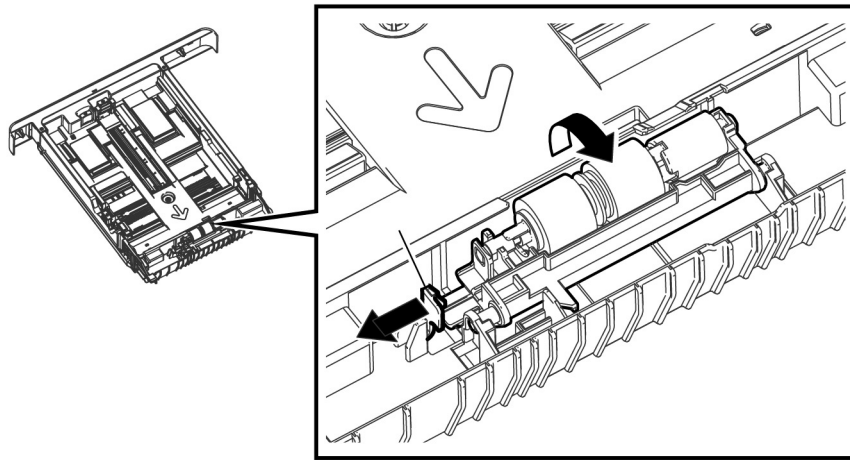
1. Remove the 550 Cassette Assembly from the printer.
2. Refer to Figure 1 to release the hook at the end of the Cassette Separator Holder, then lift the holder in the direction of the arrow.

Figure 1 Release the Cassette Separator Holder Hook

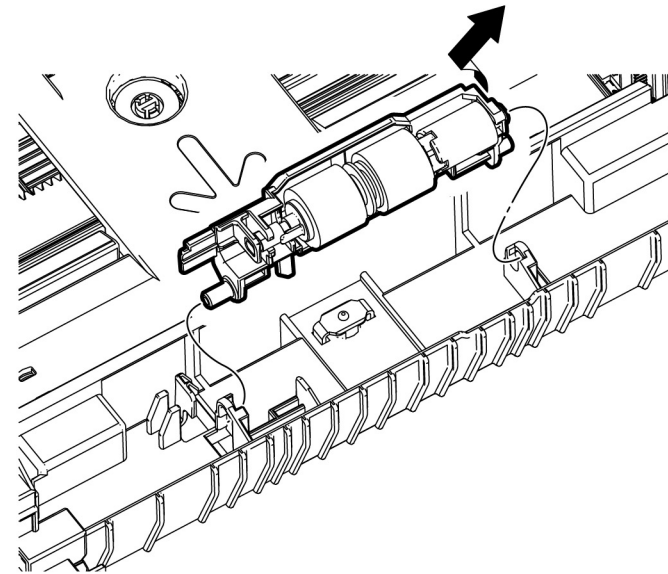
3. Refer to Figure 2 to remove the Cassette Separator Holder in the direction of the arrow.

Figure 2 Remove the Cassette Separator Roller Assembly

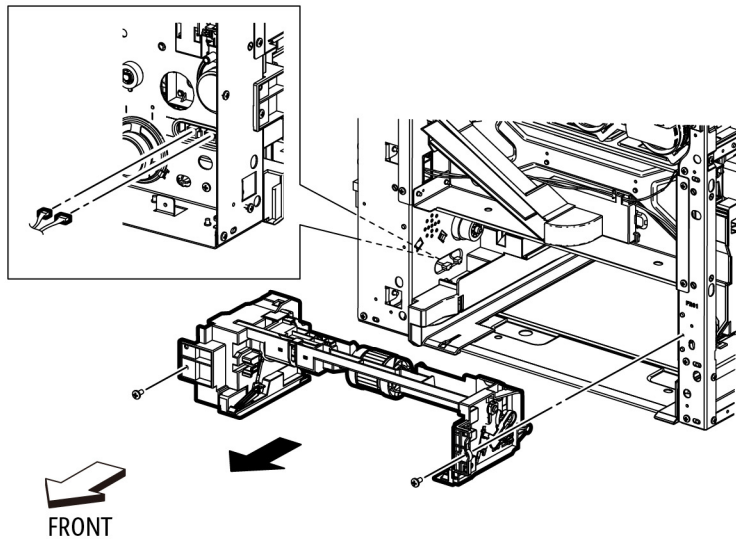
1. Remove the Front Inner Cover; REP 19.1.5 (MFP), REP 19.3.5 (SFP).
2. Remove the LVPS Board; REP 18.1.16 (MFP), REP 18.5.16 (SFP).
3. Remove the LVPS Plate; REP 18.1.20 (MFP), REP 18.5.20 (SFP).
4. Remove the Bypass Drive Assembly; REP 3.1.3.
5. Refer to Figure 1 to unplug the connectors (P/J482, P/J483).

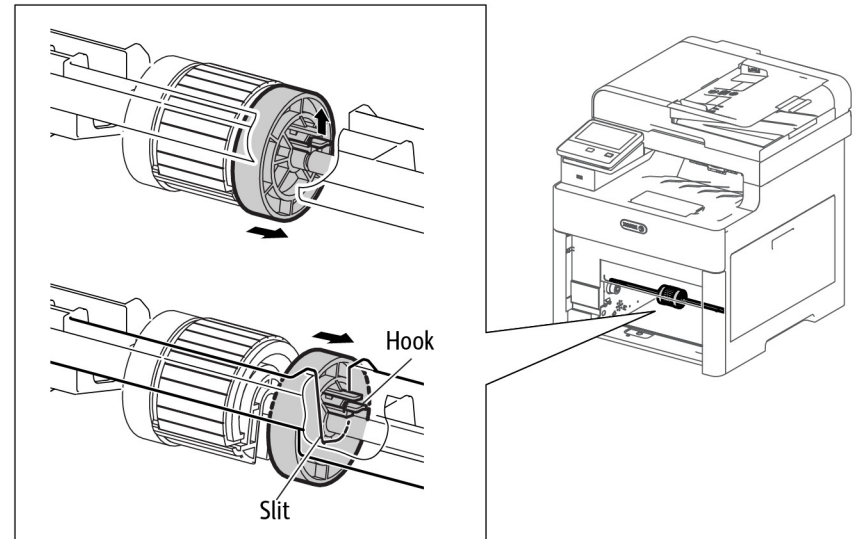
1. Remove the Main Bypass Tray Assembly; REP 13.2.1.
2. Refer to Figure 1 to release the hook on the Bypass Core Roll.

Figure 1 Release the Bypass Tray Feed Roller Hook

3. Refer to Figure 1 to rotate the Bypass Core Roll and move it in the direction of the arrow until the Core Roll slides completely against the Bypass Frame Housing.
4. Refer to Figure 2 to slide and rotate the Feed Roller in the direction of the arrows until it releases from the shaft.

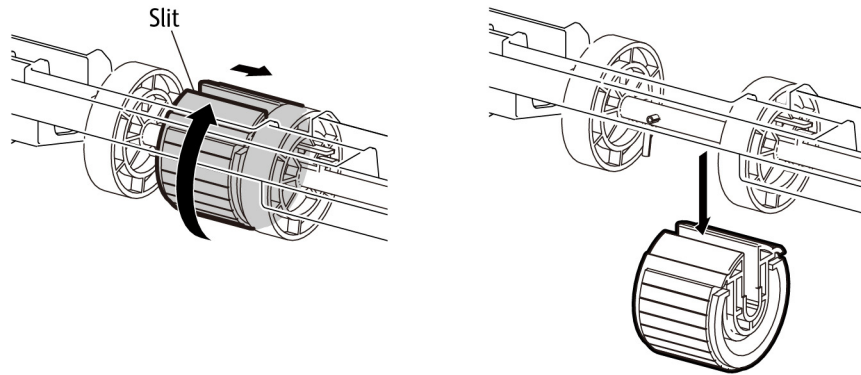
Figure 2 Remove the Bypass Tray Feed Roller

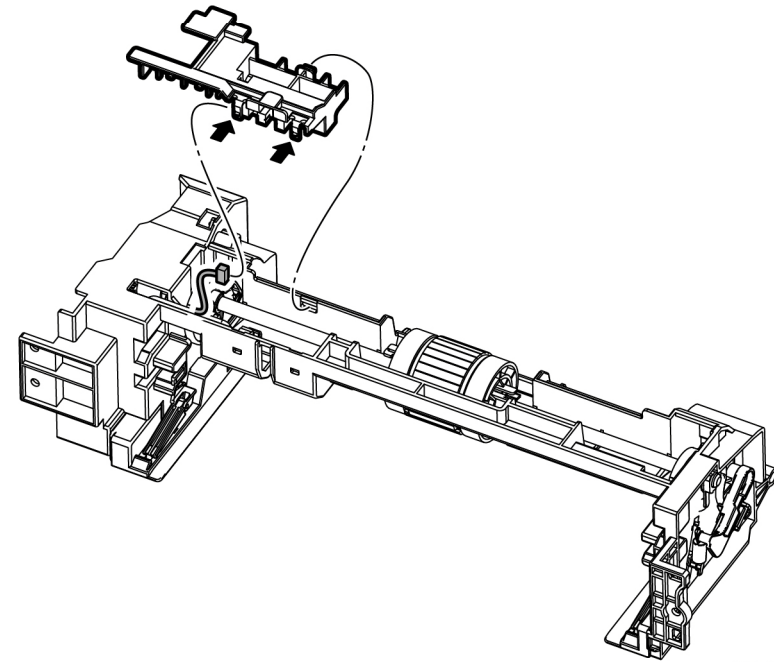
1. Remove the Bypass Tray Frame Assembly, REP 13.1.1.
2. Refer to Figure 1 to release the two hooks and the boss, and lift up the Bypass No Paper Bracket (with the No Paper Sensor) from the Bypass Tray Frame Assembly.

Figure 1 Remove the Bypass Tray No Paper Bracket

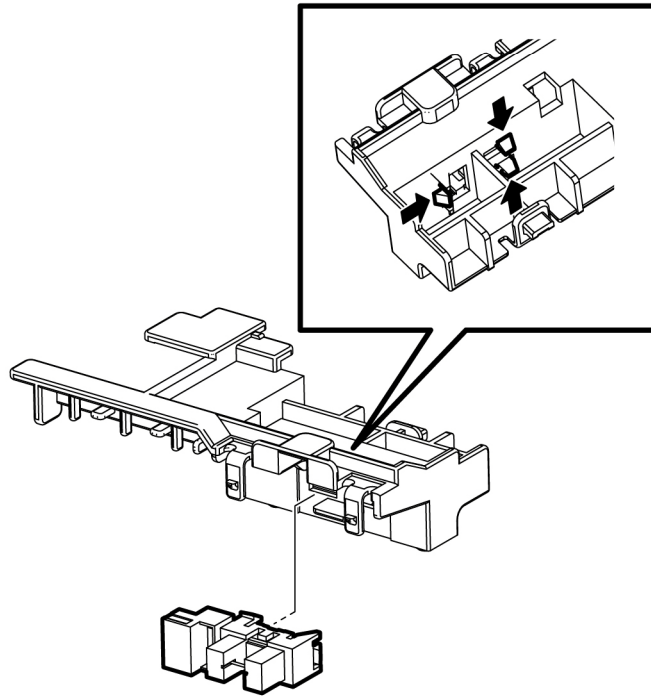
Figure 2 Remove the Bypass Tray No Paper Sensor

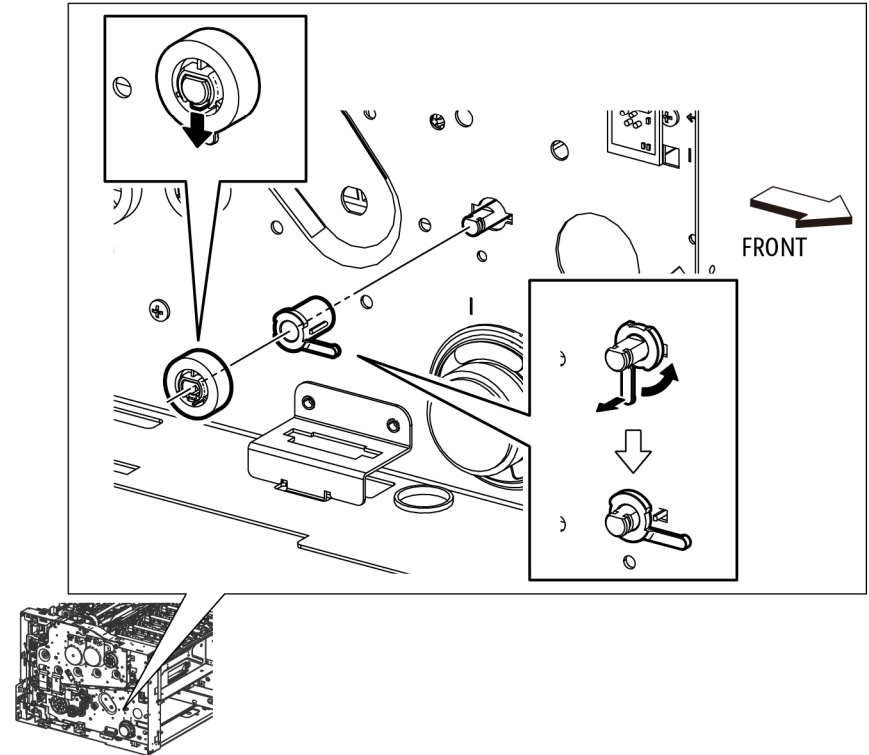
1. Remove the Bypass Tray Frame Assembly, REP 13.1.1.
2. Refer to Figure 1 to release the hook holding the Turn Gear, and remove the gear.

Figure 1 Remove the Turn Gear and Left TA Bearing

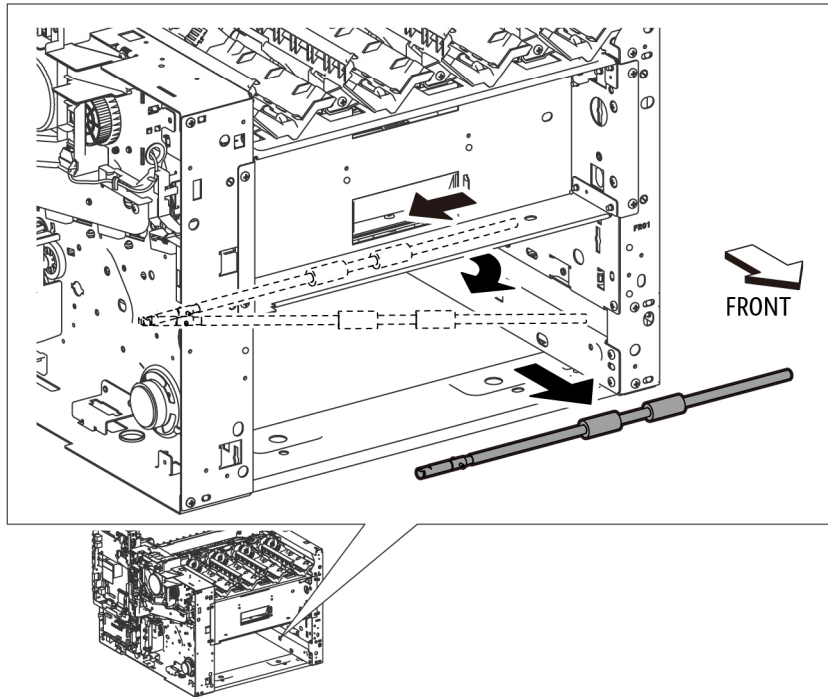
Figure 2 Remove the Bypass Tray TA1 Roller Assembly

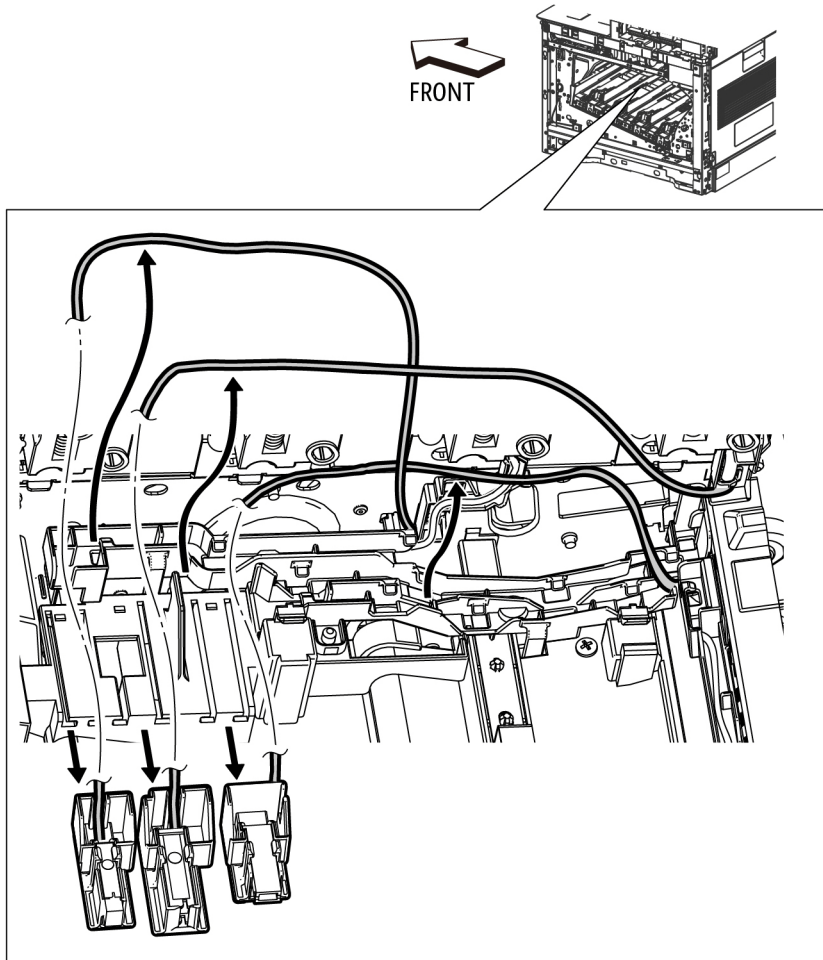
1. Remove the Right Side Cover; REP 19.1.97 (MFP), REP 19.3.97 (SFP).
2. Remove the Left Side Cover; REP 19.2.1 (MFP), REP 19.4.1 (SFP).
3. Remove the Front Inner Cover; REP 19.1.5 (MFP), REP 19.3.5 (SFP).
4. Remove the Transfer Belt Unit, REP 6.1.1.
5. Remove the Drum Cartridge (Y,M,C,K) and Guide Cover Assembly, REP 8.1.1.
6. Remove the LPH Color Head Assembly, REP 2.1.1.
7. Remove the PH Drive Assembly, REP 3.1.2.
8. Remove the MSI Drive Assembly, REP 3.1.3.
9. Remove the LPH Xerographic CRUM FFC Kit, REP 2.1.99.
10. Remove the HVPS Guide Assembly; REP 18.2.1 (MFP), REP 18.6.1 (SFP).
11. Refer to Figure 1 to release the three harnesses from the Harness Guide and remove the Holder Assembly.

Figure 1 Release the Harnesses

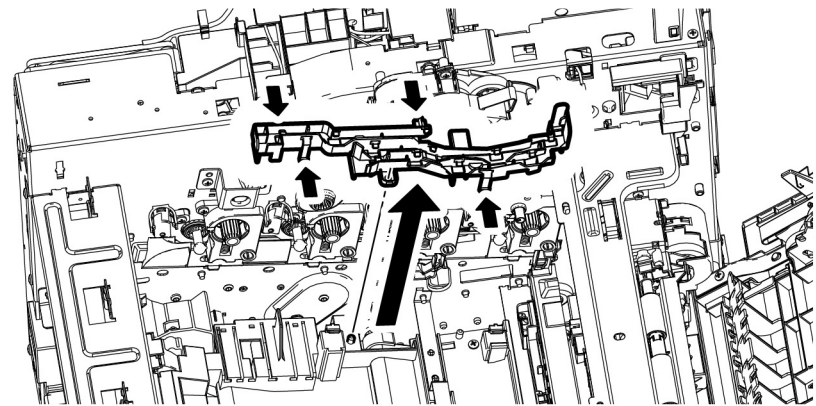
12. Refer to Figure 2 to release the two hooks and the three bosses, then remove the Harness Guide.

Figure 2 Remove the Harness Guide

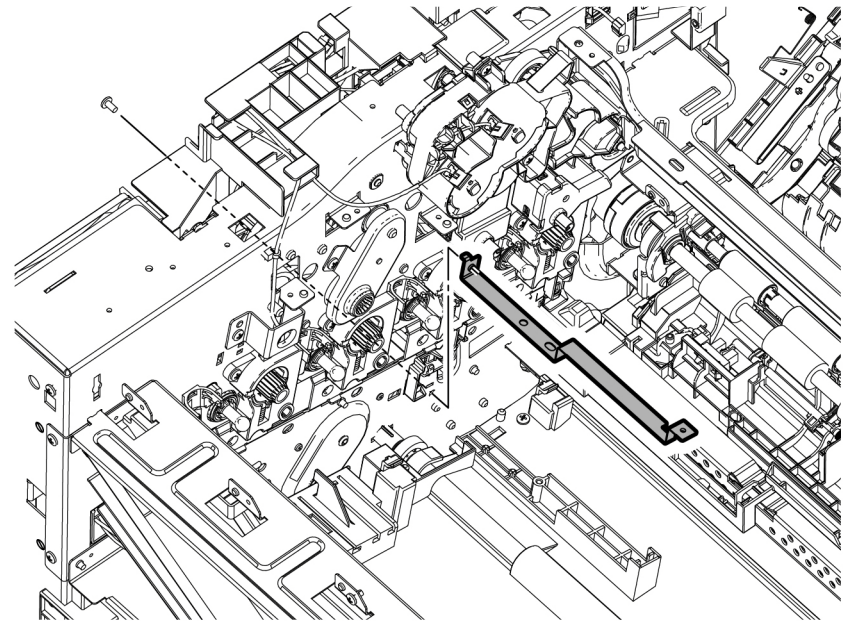
13. Refer to Figure 3 to remove the one screw (silver, M3x6mm) attaching the Plate and remove the Plate.

Figure 3 Remove the Plate

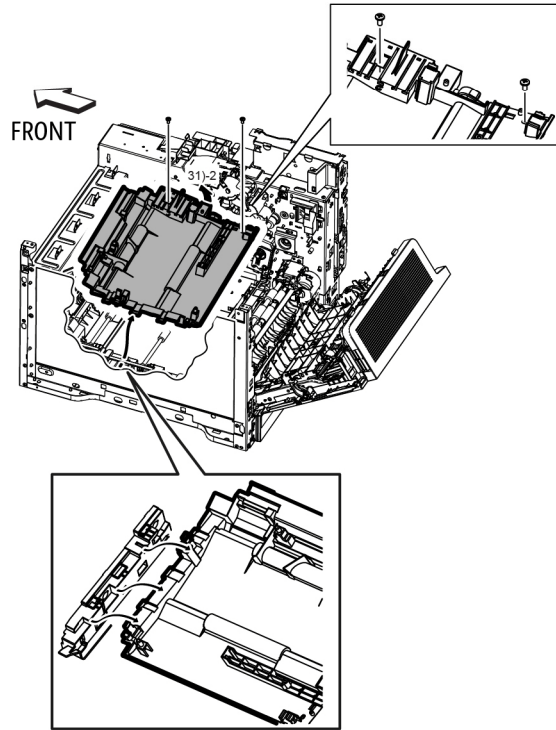
- Refer to Figure 4 to remove the two screws (silver, tapping, M3x8mm) attaching the MSI Upper Chute (PL13.1.15) and lift up the MSI Upper Chute.

Figure 4 Detach the MSI Upper Chute

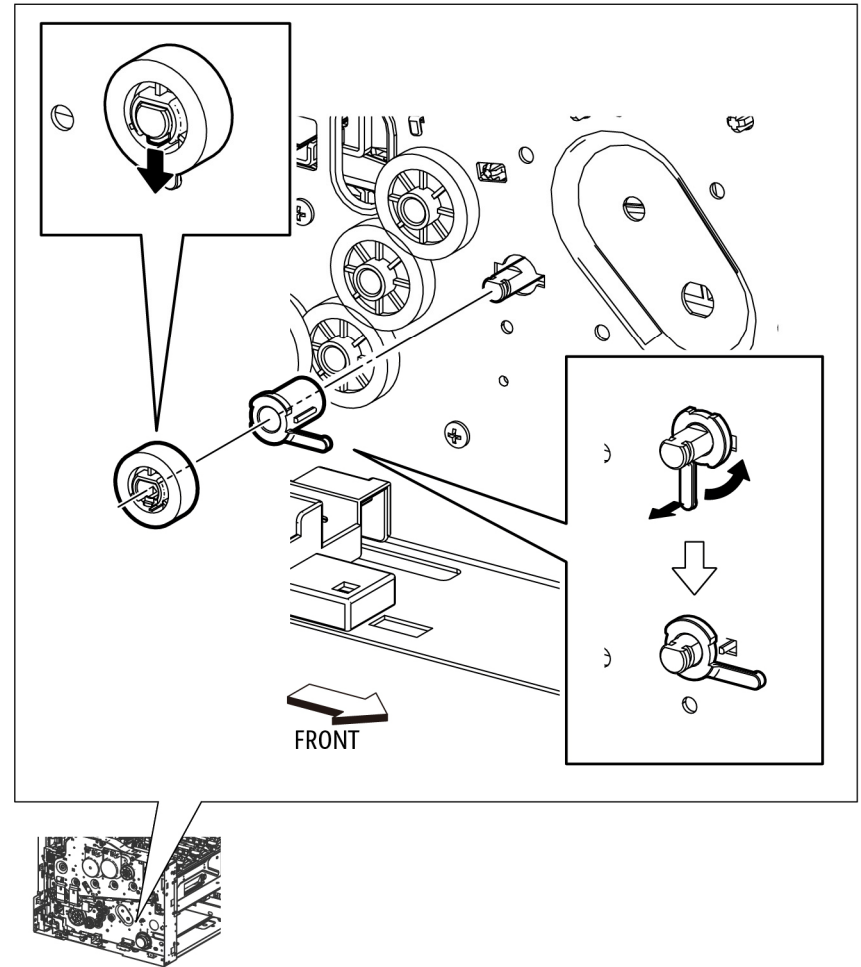
- Refer to Figure 5 to release the hook and remove the Turn Gear.

Figure 5 Remove the Turn Gear and Left TA Bearing

- Refer to Figure 5 to unlock the Left TA Bearing by lifting the tab, then rotate and remove it.
- Refer to Figure 6 to slide the Bypass Tray TA2 Roller Assembly, then remove the TA2 Roller in the direction of the arrows.

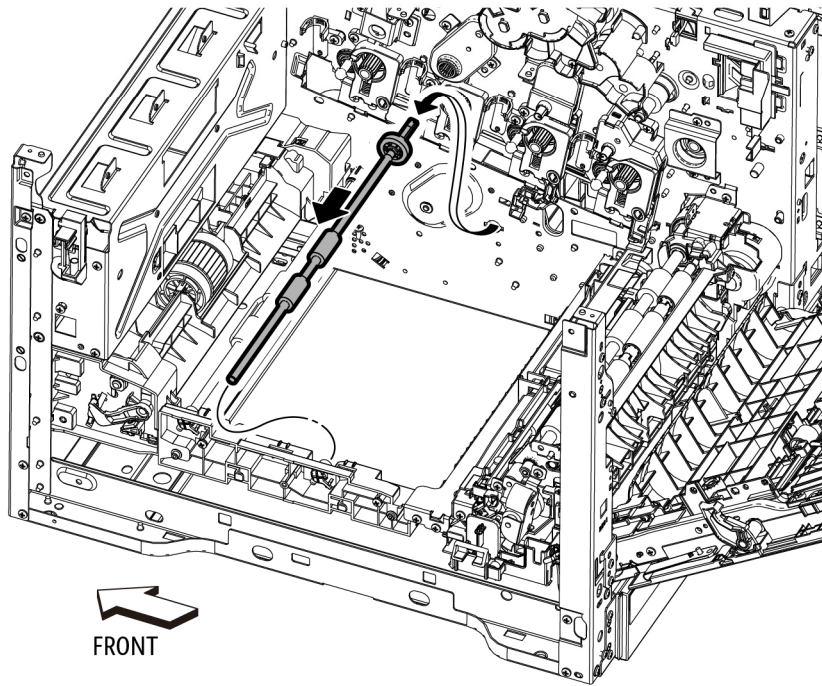
Figure 6 Remove the Bypass Tray TA2 Roller Assembly

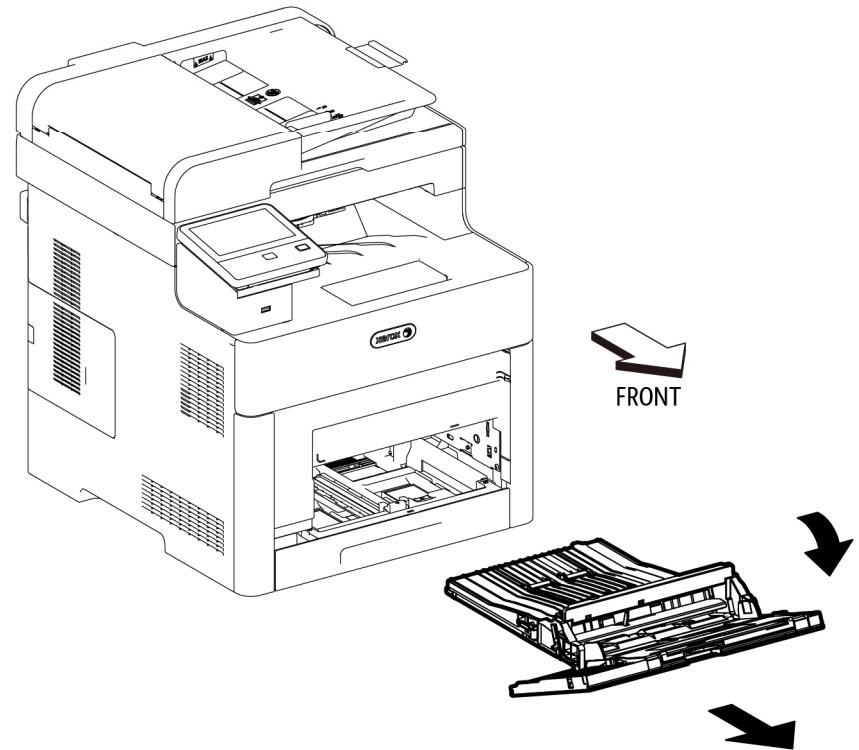
1. Refer to Figure 1 to open the Main Bypass Tray.

Figure 1 Remove the Main Bypass Tray Assembly

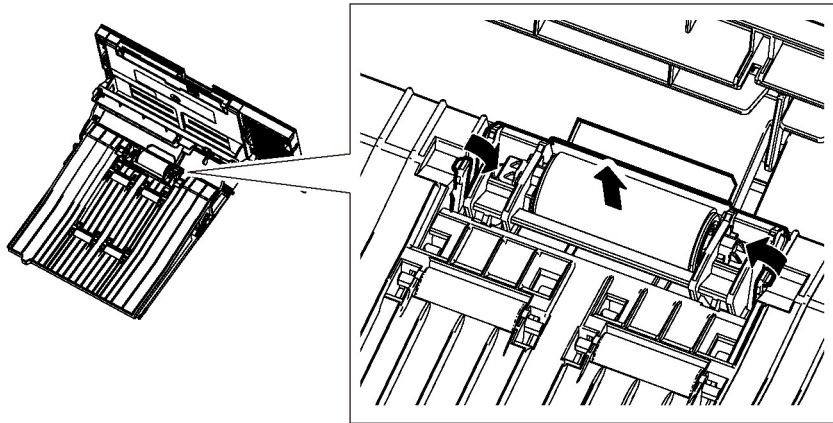
1. Remove the Main Bypass Tray Assembly, REP 13.2.1.
2. Refer to Figure 1 to release the hook of the Bypass Tray Separator Holder Assembly and remove the Bypass Tray Separator Holder from the Main Bypass Tray.

Figure 1 Remove the Bypass Tray Separator Holder Assembly
