Phaser® 6510, WorkCentre® 6515 Service Manual

Xerox Phaser 6510 Color Printer/WorkCentre 6515 Color Multifunction Printer

Phaser 6510 Color Printer/WorkCentre 6515 Color Multifunction Printer Service Manual

705P01382

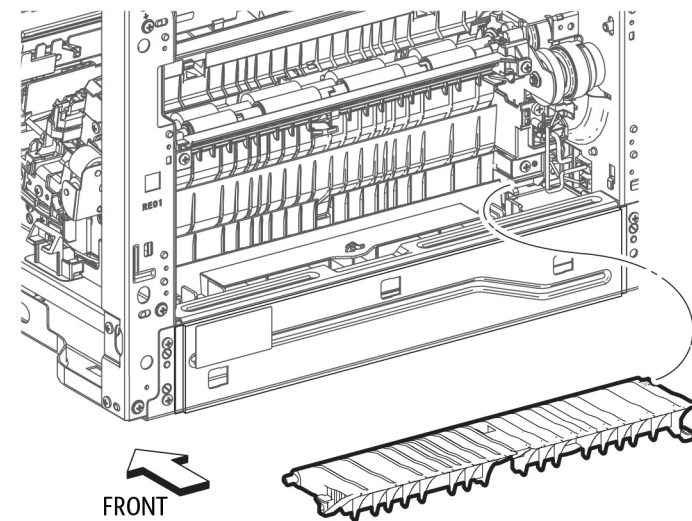
1. Remove the Right Side Cover; REP 19.1.97 (MFP), REP 19.3.97 (SFP)
2. Remove the Rear Cover; REP 19.2.99 (MFP), REP 19.4.99 (SFP).
3. Refer to Figure 1 to remove the Lower Duplex Chute.

Figure 1 Remove the Lower Duplex Chute

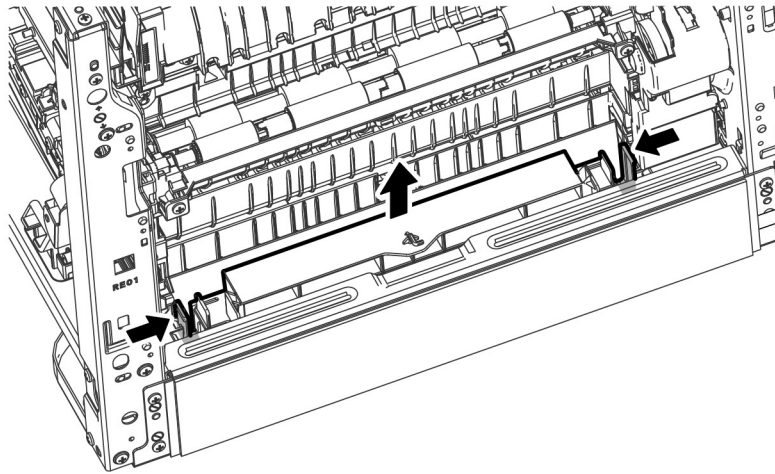
4. Refer to Figure 2 to release two hooks and remove the Option Registration Chute.

Figure 2 Remove the Option Registration Chute

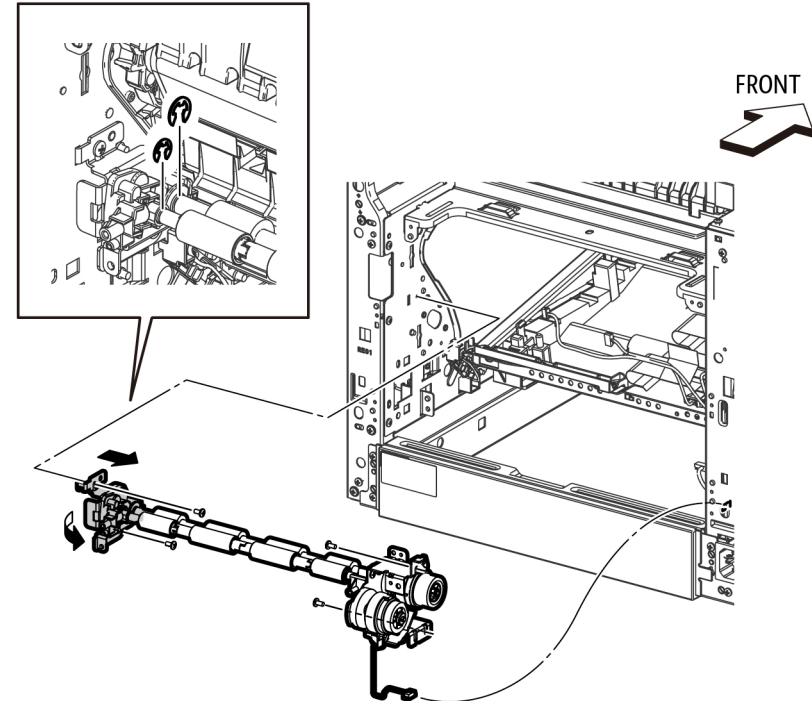
1. Remove the Registration Chute Feeder Assembly, REP 15.2.1.
2. Refer to Figure 1 to unplug the connector (P/J541).

Figure 1 Remove the Duplex Registration Roller Assembly

NOTE: When removing the Duplex Roller Registration Assembly, bearings and gears will move out of their seated positions. For easier replacement later, carefully observe the placement and orientation of bearings and gears at both ends of the roller assembly before removing it.

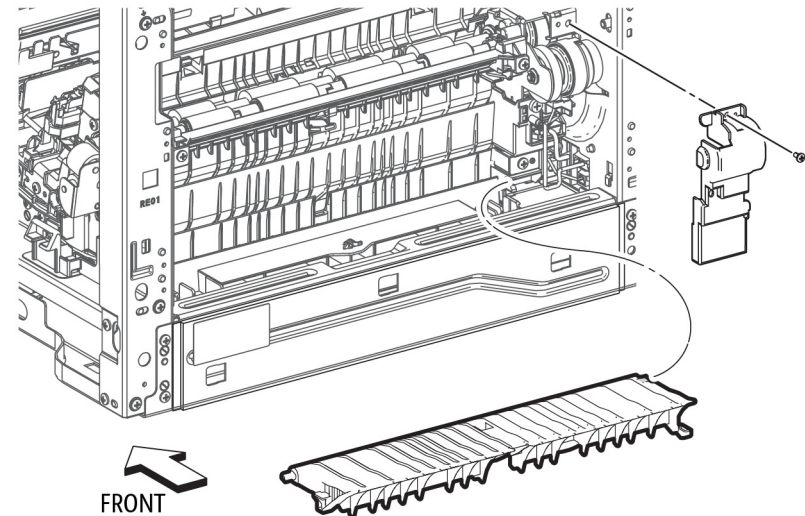
1. Remove the Right Side Cover; REP 19.1.97 (MFP), REP 19.3.97 (SFP)
2. Remove the Rear Cover; REP 19.2.99 (MFP), REP 19.4.99 (SFP).
3. Refer to Figure 1 to remove the one screw (silver, M3x6mm) attaching the Rear Duplex Cover and remove the cover.

Figure 1 Remove the Rear Duplex Cover and Lower Duplex Chute

4. Refer to Figure 1 to rotate the Lower Duplex Chute 90 degrees toward the rear, and remove the Lower Duplex Chute.
5. Remove the 250 Option Registration Chute, REP 15.1.1.
6. Refer to Figure 2 to remove the two screws (silver, tapping, M3x8mm) attaching the Upper Duplex Chute and remove the chute.

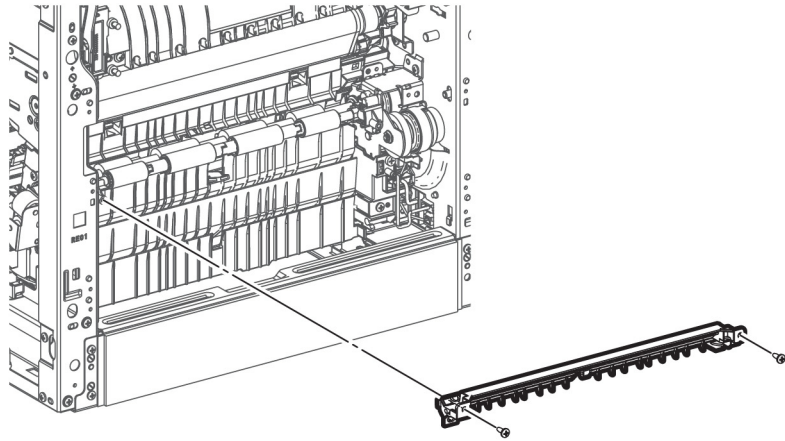
Figure 2 Remove the Upper Duplex Chute

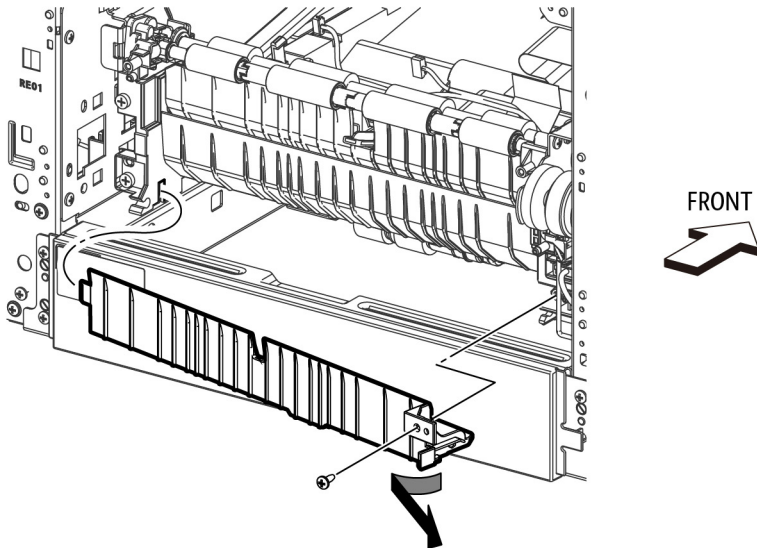
7. Remove the Second Bias Transfer Housing Kit; REP 18.2.99 (MFP), REP 18.6.99 (SFP).
8. Refer to Figure 3 to remove the screw (silver, tapping, M3x8mm) attaching the Feeder Chute and pull out the chute in the direction of the arrow.

Figure 3 Remove the Feeder Chute

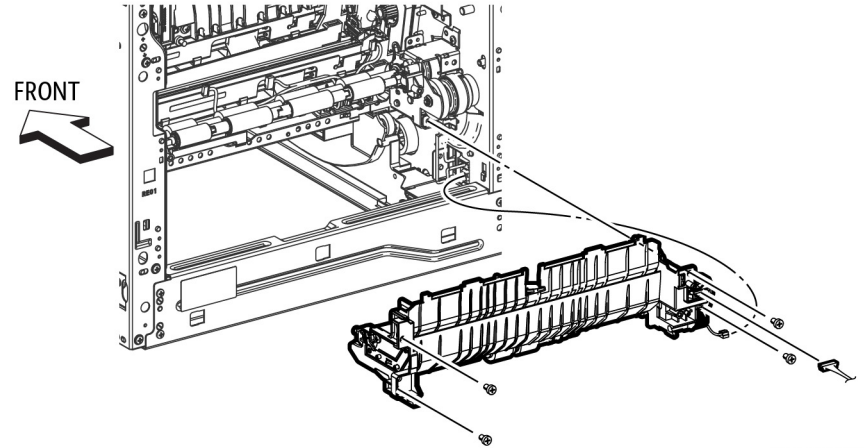
9. Refer to Figure 4 to unplug the two connectors (P/J544, P/J545).

Figure 4 Remove the Registration Chute Feeder

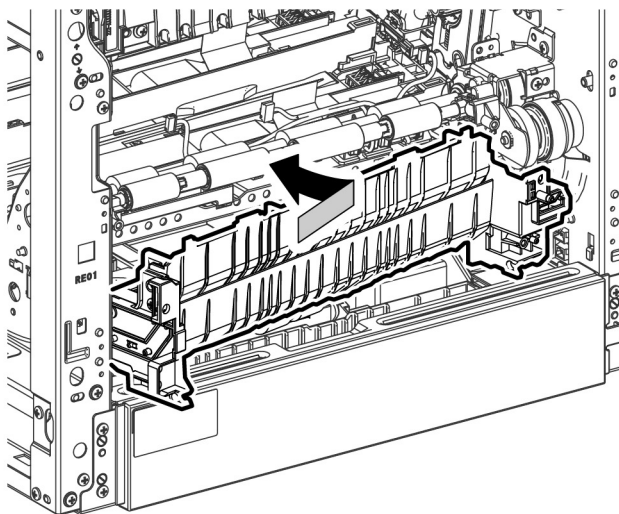
When installing the Registration Chute Feeder, install it at the angle shown in Figure 5.

Figure 5 Observe Angle When Installing Feeder

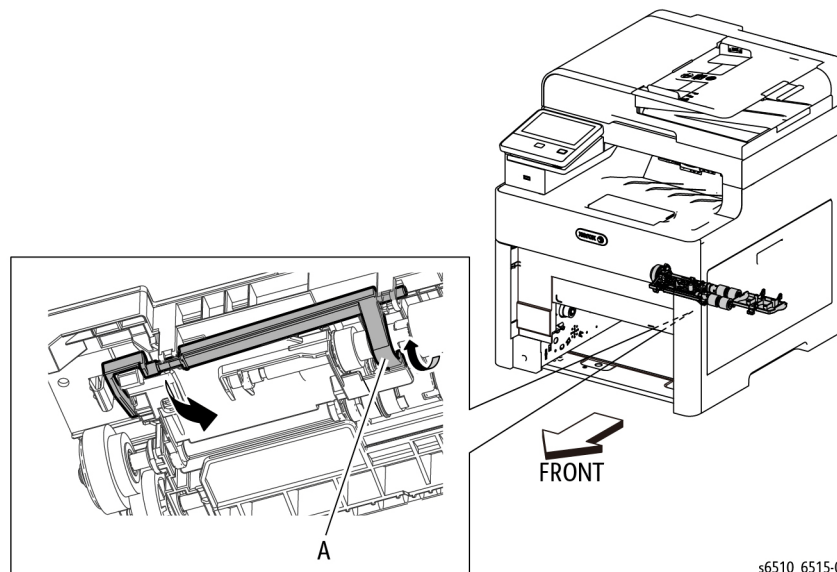
1. Remove the 250 Cassette Assembly.
2. Remove the Main Bypass Tray Assembly.
3. Refer to Figure 1 to release tab A of the No Paper Actuator in the direction of the arrow and fully rotate the actuator.

Figure 1 Remove the No Paper Actuator

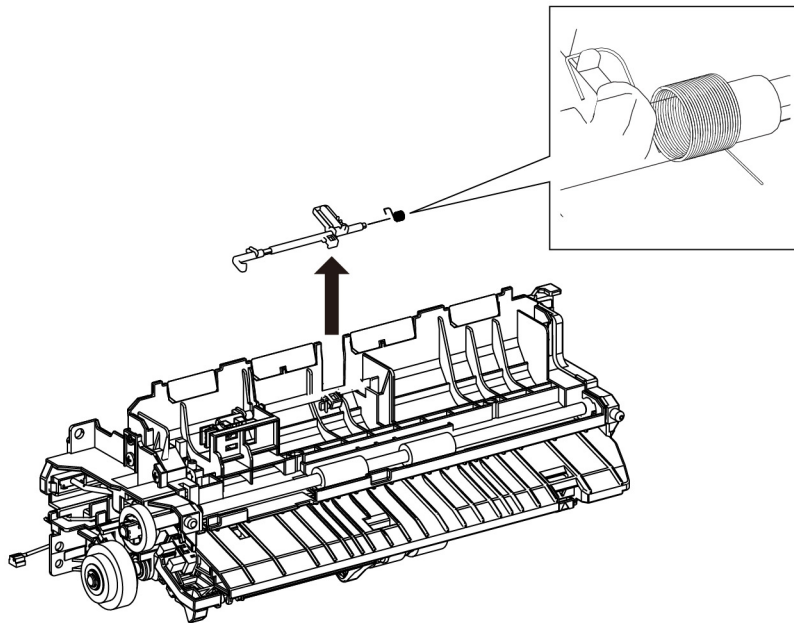
s6510_6515-076

2. Referring to Figure 1, use a flat-blade tool to release the left end of the Registration Actuator, then release the right end and remove the Registration Actuator from the Registration Chute Feeder Assembly.

Figure 1 Remove the Registration Actuator

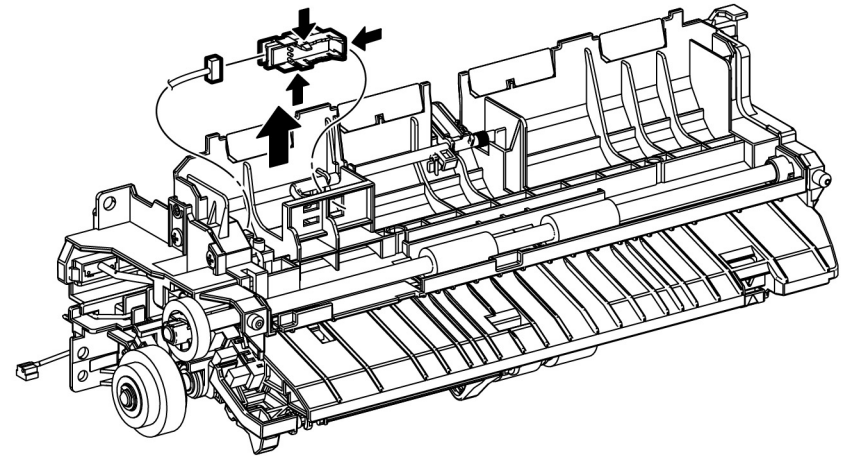
s6510_6515-077

1. Remove the Registration Chute Feeder Assembly, REP 15.2.1.
2. Refer to Figure 1 to release the double hooks, then remove the Registration Photo Sensor from the Registration Chute Feeder Assembly.

Figure 1 Remove the Registration Photo Sensor

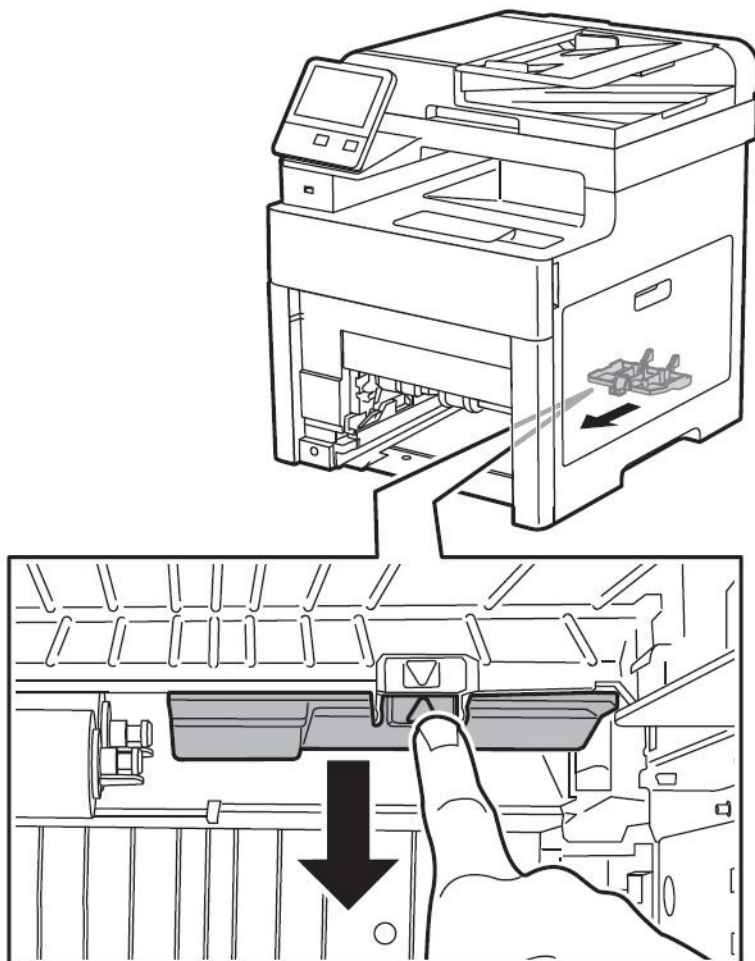
s6510_6515-118b

1. Remove the 250 Cassette Assembly.
2. Remove the Main Bypass Tray Assembly.
3. Refer to Figure 1 to remove the Upper Feed Chute.

Figure 1 Remove the Upper Feed Chute

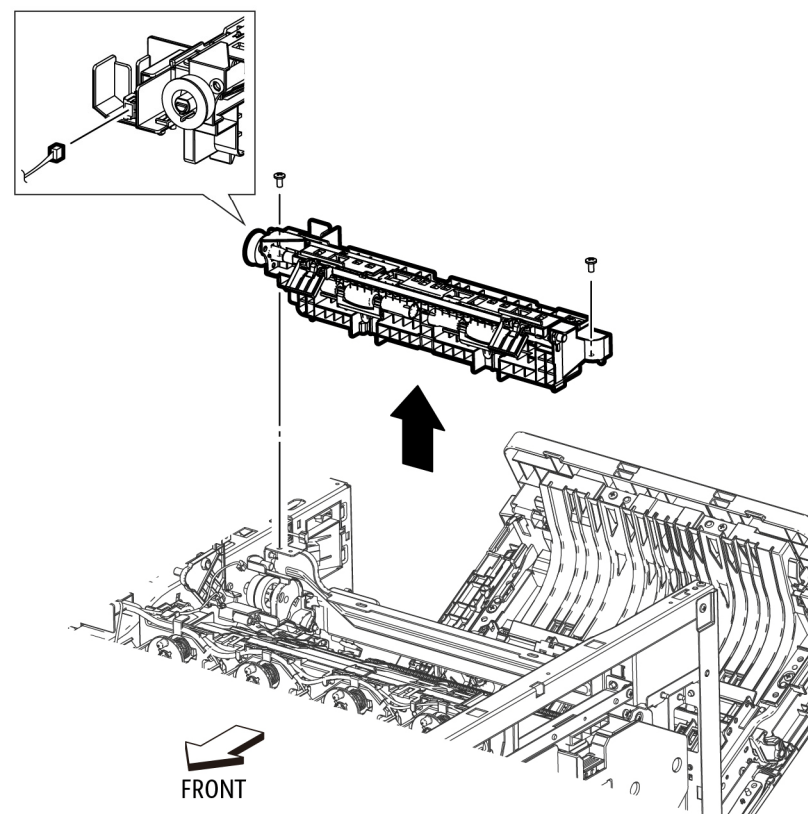
s6510_6515-078

1. Remove the Top Cover Assembly; REP 19.1.99 (MFP), REP 19.3.99 (SFP).
2. Remove the Main Exit Drive Assembly, REP 17.1.4.
3. Refer to Figure 1 to remove the two screws (silver, M3x6mm) and remove the Exit Chute Assembly.

Figure 1 Remove the Exit Chute Assembly

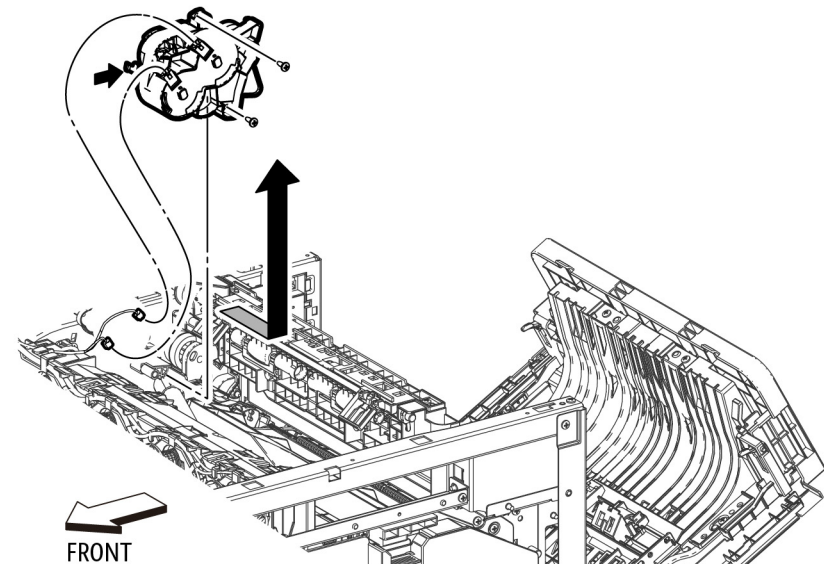
s6510_6515-079

1. Remove the Top Cover Assembly; REP 19.1.99 (MFP), REP 19.3.99 (SFP).
2. Open the Rear Cover.
3. Refer to Figure 1 to unplug the connectors (P/J461, P/J462) and release the harness.

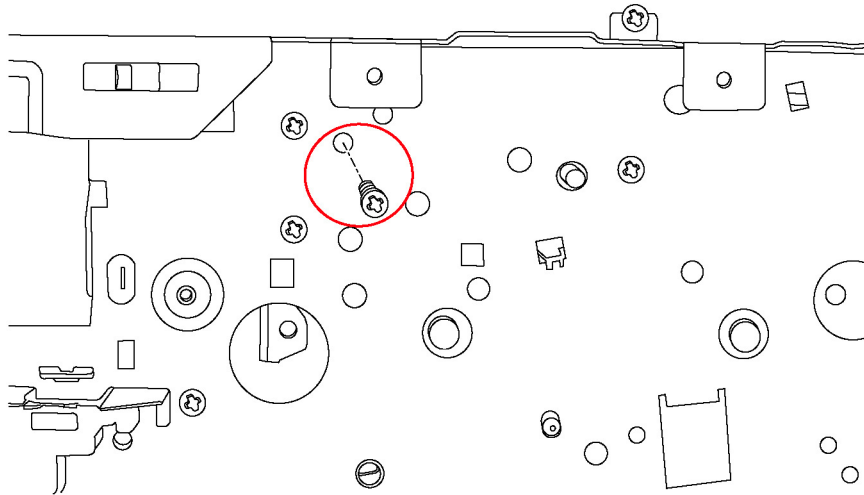
s6510_6515-173

1. Remove the Top Cover Assembly; REP 19.1.99 (MFP), REP 19.3.99 (SFP).
2. Open the Rear Cover.
3. Remove the Exit Chute Assembly, REP 17.1.1.
4. Remove the Main Drive, REP 3.1.1.
5. Refer to Figure 1 to remove the one screw (silver, tapping, M3x8mm) from the left side of the printer frame attaching the Exit Idle Gear Assembly, and remove the gear assembly.

Figure 1 Remove the Right Side Cover Assembly

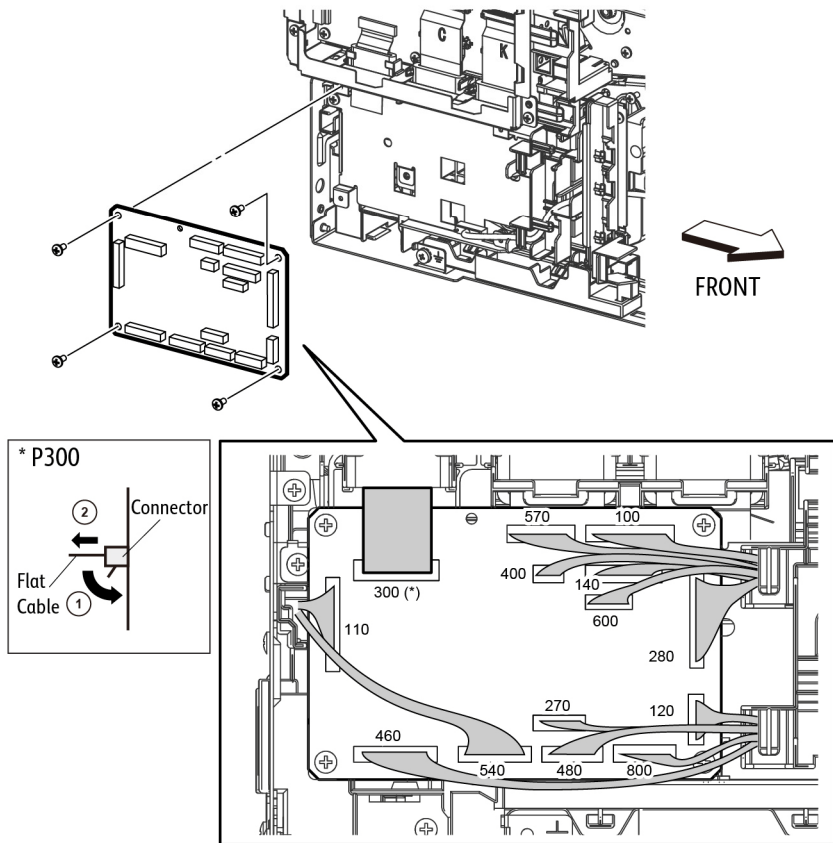
1. Remove the Left Side Cover, REP 19.2.1.
2. Refer to Figure 1 to remove the two screws (silver, M3x6mm) attaching the ESS Lower Plate and remove the plate.

Figure 1 Remove the MCU Board (MFP)

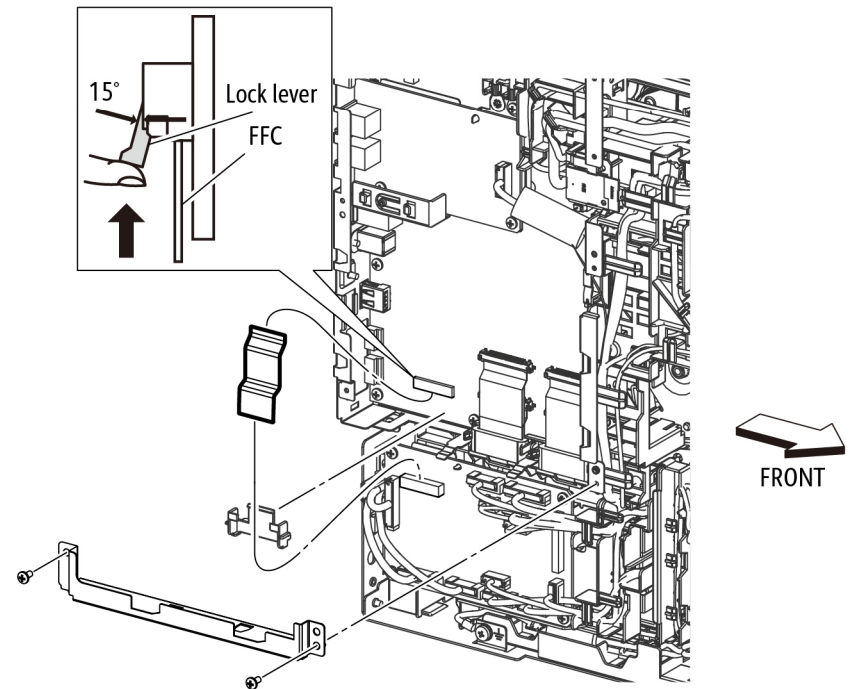
3. Refer to Figure 1 to remove the four screws (silver, M3x6mm) attaching the MCU Board and remove the board.

Figure 1 Remove the ESS MCU FFC (MFP)

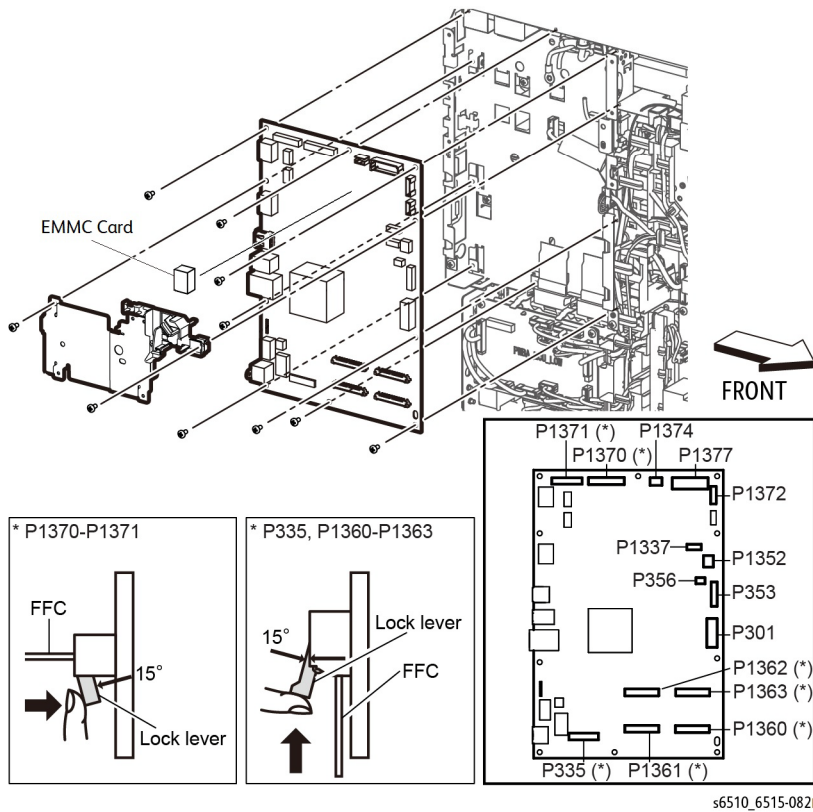
1. Remove the Left Side Cover, REP 19.2.1.
 2. Remove the ESS Top Plate, REP 18.1.18.
 3. Remove the FAX Board, REP 18.1.9.
 4. Refer to Figure 1 to remove the two screws (silver, M3x6mm) attaching the FAX Plate and remove the FAX Plate with the ESS Harness Guide.

Figure 1 Remove the ESS Board (MFP)

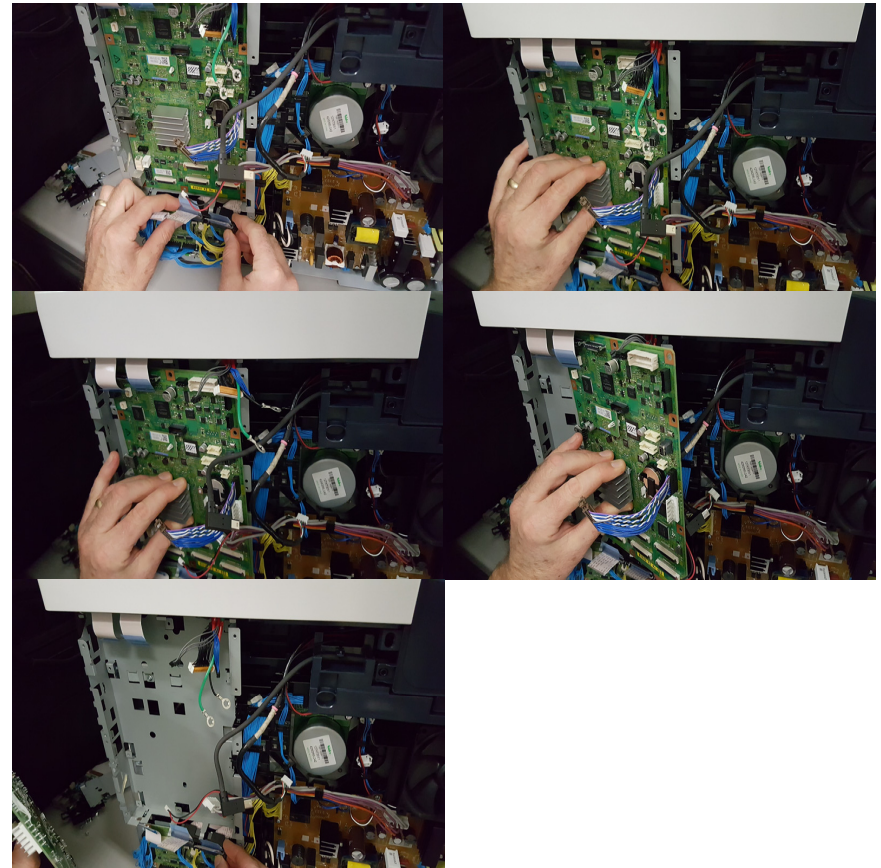
NOTE: In the following step, when releasing the lock lever on the FFC connector, slightly open the lock lever to 15 degrees until the lock lever contacts the FFC connector as shown in Figure 1. After releasing the lock lever, hold the lever while gently pulling the FFC from the connector.

- Refer to Figure 1 to unplug the FFCs (P/J1360, P/J1361, P/J1362, P/J1363, P/J335) and the connectors (P/J301, P/J353, P/J356, P/J1337, P/J1352, P/J1370, P/J1371, P/J1372, P/J1374, P/J1377). When unplugging the FFC (P/J335), keep the cable clamp open
- Refer to Figure 1 to remove the eight screws (silver, M3x6mm) that attach the ESS Board to the ESS Box and remove the board.
- Refer to Figure 2 to carefully move the harnesses out of the way and remove the ESS Board from the frame leaving all harnesses and guides in-place.

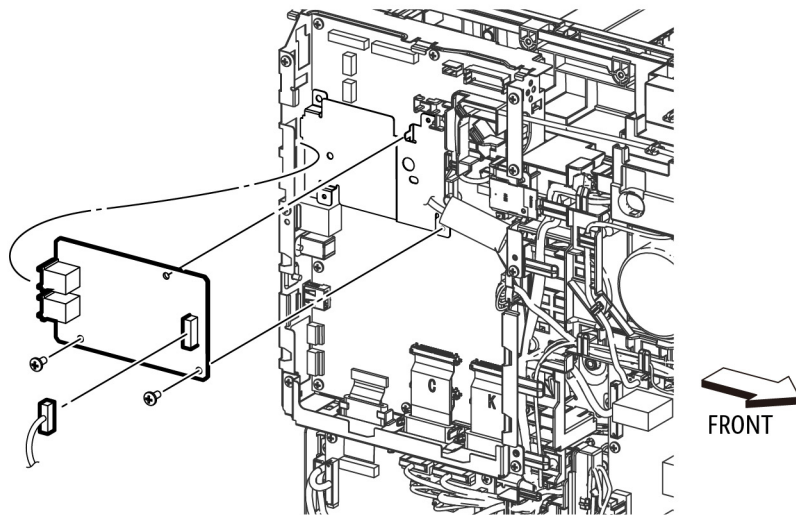
s6510_6515-083

1. Remove the Left Side Cover, REP 19.2.1.
2. Remove the ESS Top Plate, REP 18.1.18.
3. Unplug the connector (P/J1350) from the FAX Board.
4. Refer to Figure 1 to remove the two screws (silver, M3x6mm) attaching the FAX Board.

Figure 1 Remove the FAX Board (MFP)

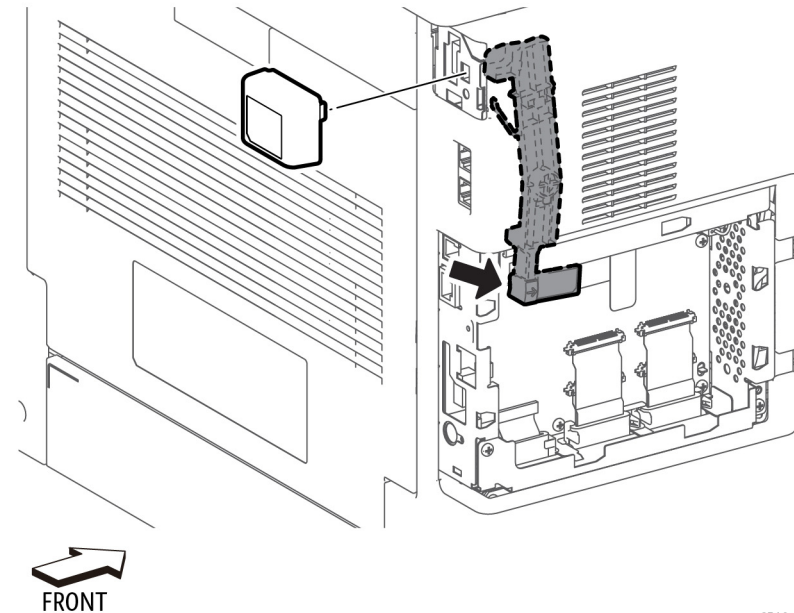
s6510_6515-084

1. Remove the ESS Window, REP 19.2.98.
2. Refer to Figure 1 to push the WIFI Link in the direction of the arrow to remove the Wireless Module.

Figure 1 Remove the WIFI Module (MFP)

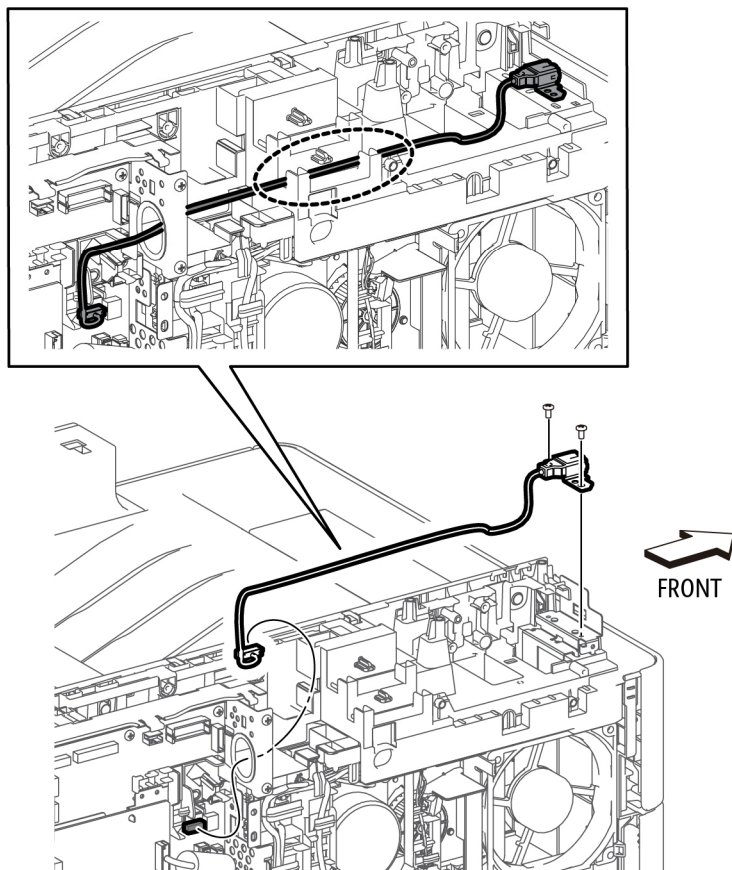
s6510_6515-085

1. Remove the Left Side Cover, REP 19.2.1.
2. Remove the ESS Top Plate, REP 18.1.18.
3. Remove the UI Frame Assembly, REP 1.1.99.
4. Refer to Figure 1 to unplug the USB Harness connector (P/J1337) from the ESS Board.

Figure 1 Remove the Front USB Harness Assembly (MFP)

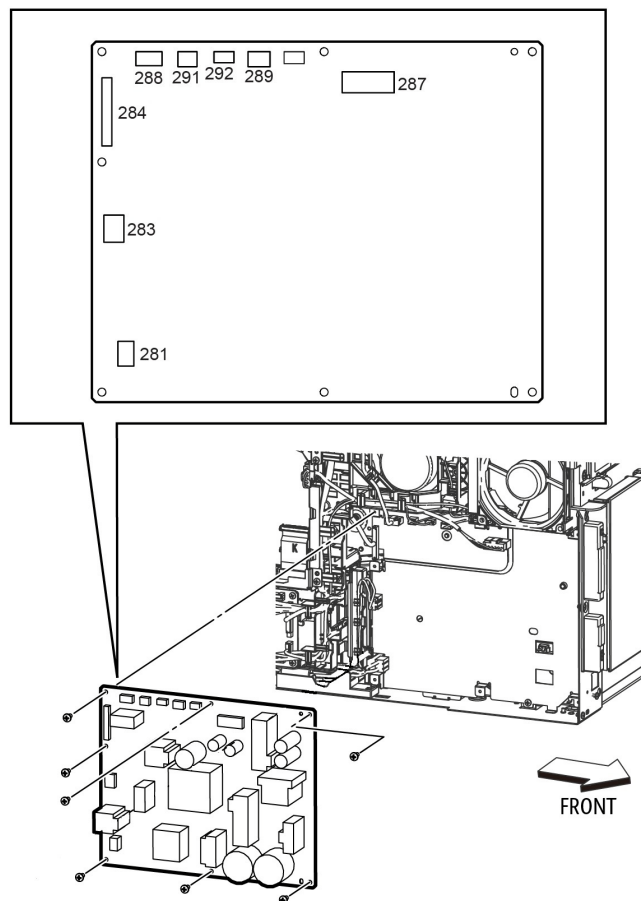
s6510_6515-086b

1. Remove the Left Side Cover, REP 19.2.1.
2. Refer to Figure 1 to unplug the connectors (P/J281, P/J283, P/J284, P/J287, P/J288, P/J289, P/J291, P/J292) from the LVPS Board.
3. Refer to Figure 1 to remove the seven screws (silver, M3x6mm) attaching the LVPS Board to the LVPS Plate.

Figure 1 Remove the LVPS Board (MFP)

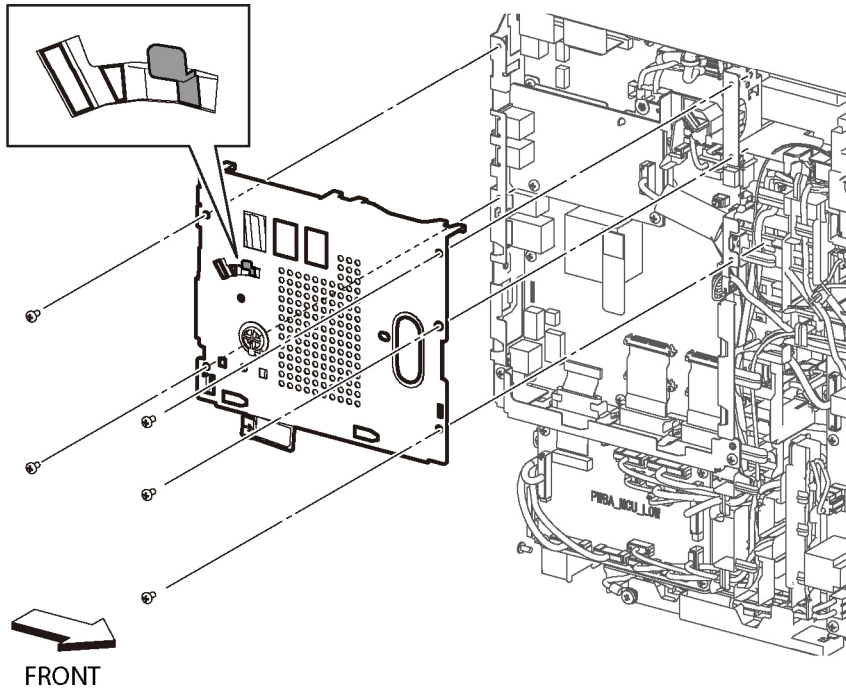
s6510_6515-087

1. Remove the Left Side Cover, REP 19.2.1. REP 19.2.1
2. Refer to Figure 1 to remove the five screws (silver, M3x6mm), and remove the ESS Top Plate making sure to retain the WIFI Link with the plate.

Figure 1 Remove the ESS Top Plate (MFP)

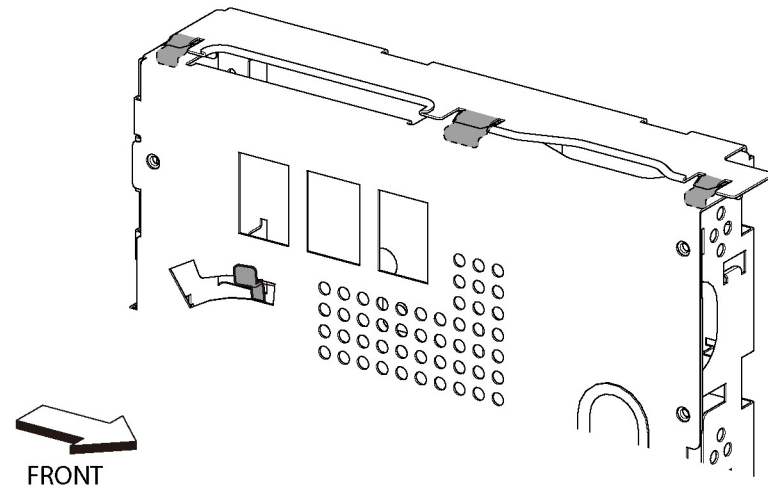
s6510_6515-088

1. Make sure the WIFI Link is locked into the ESS Top Plate and rotated clockwise as shown in Figure 2.
2. Position the ESS Top Plate so the three hooks of the ESS Box are inserted under the ESS Top Plate as shown in Figure 2.

Figure 2 Replace the ESS Top Plate

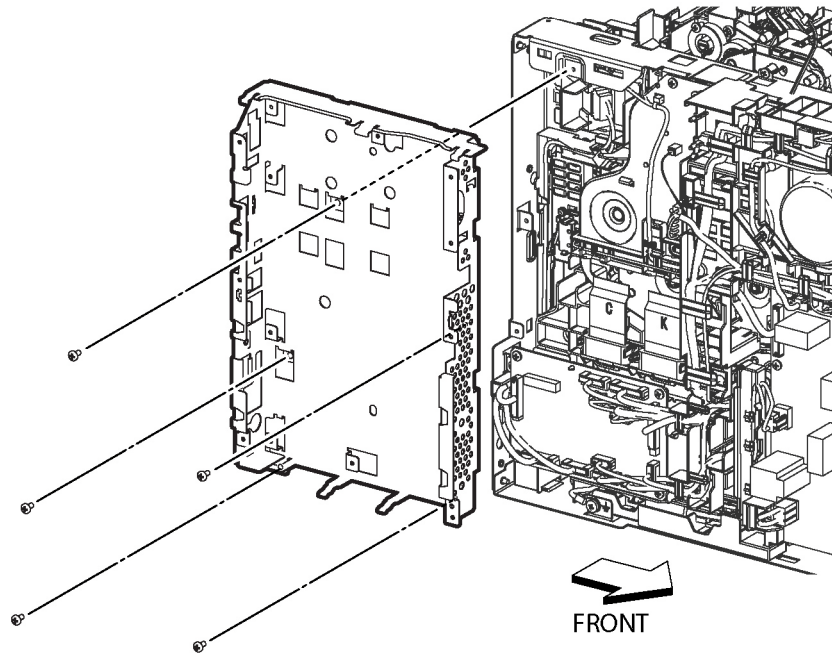
s6510_6515-124

1. Remove the Left Side Cover, REP 19.2.1.
2. Remove the ESS Board, REP 18.1.5.
3. Refer to Figure 1 to remove the five screws (silver, M3x6mm) attaching the ESS Box.

Figure 1 Remove the ESS Box (MFP)

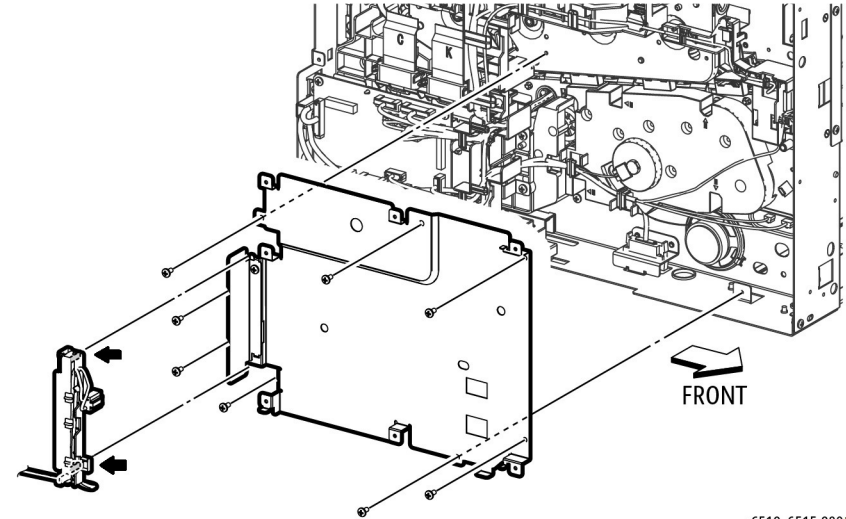
s6510_6515-089b

1. Remove the LVPS Board, REP 18.1.16.
2. Refer to Figure 1 to release the two hooks on the harness guide and remove the guide.

Figure 1 Remove the LVPS Plate

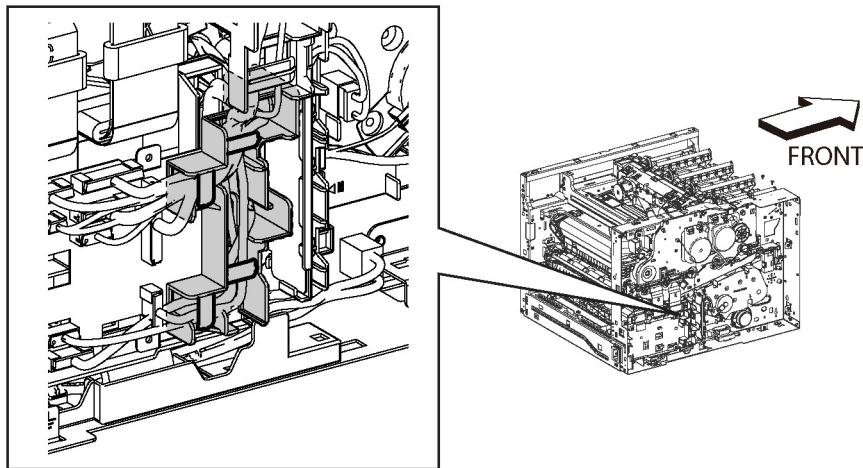
s6510_6515-125

1. Remove the Left Side Cover, REP 19.2.1.
2. Remove the MCU Board, REP 18.1.1.
3. Refer to Figure 1 to release the cables from the MCU Harness Guide and remove the guide.

Figure 1 Release the Harnesses from the MCU Plate (MFP)

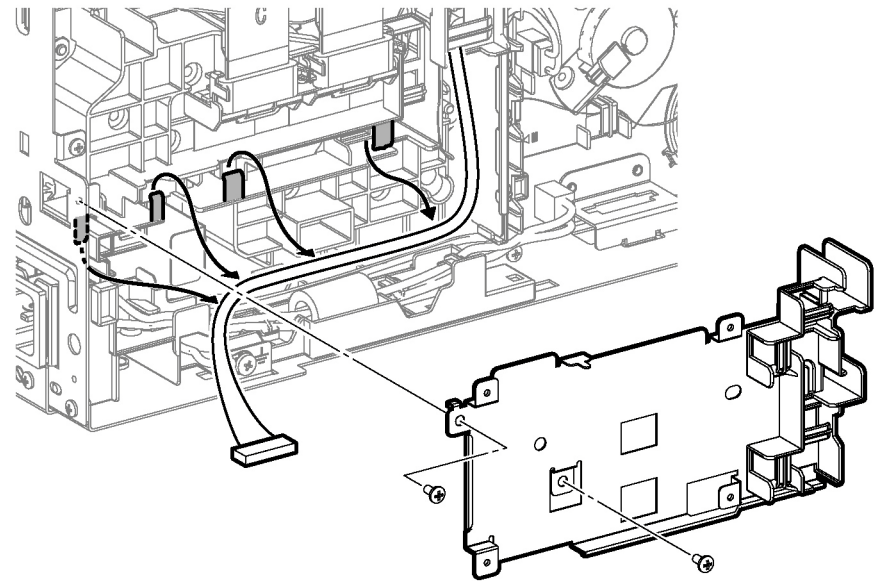
s6510_6515-126

4. Refer to Figure 2 to remove the two screws (silver, M3x6mm) attaching the MCU Plate. To release the tabs at the right edge of the MCU Plate, remove screws from left edge of the LVPS Board and LVPS Plate as needed.

Figure 2 Remove the MCU Plate (MFP)

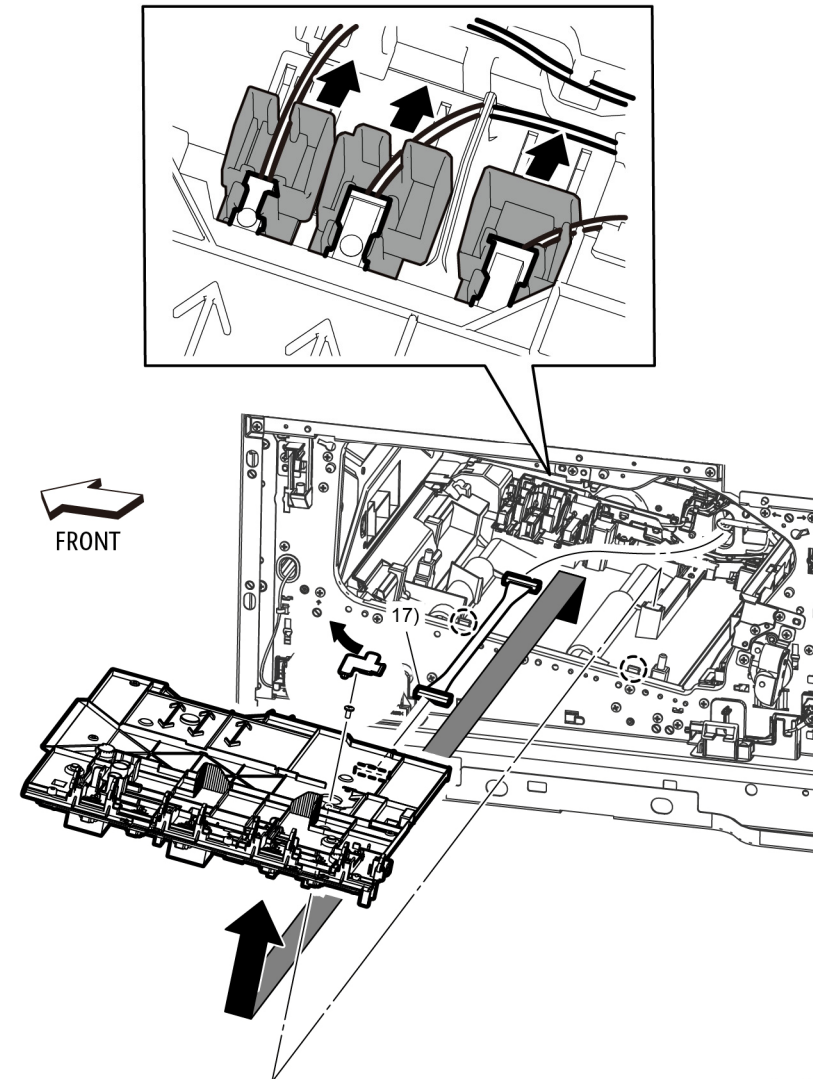
s6510_6515-090

1. Remove the Right Side Cover, REP 19.1.97.
2. Remove the Left Side Cover, REP 19.2.1.
3. Remove the Drum Cartridges Y, M, C, K, REP 8.1.1.
4. Remove the Transfer Belt Unit, REP 6.1.1.
5. Remove the LPH Color Head Assembly, REP 2.1.1.
6. Remove the MCU Board, REP 18.1.1.
7. Remove the LPH Xerographic CRUM FFC, REP 2.1.99.
8. Refer to Figure 1 to remove the HVPS Toner Cover, REP 18.2.3.

Figure 1 Remove the HVPS Guide Assembly (MFP)

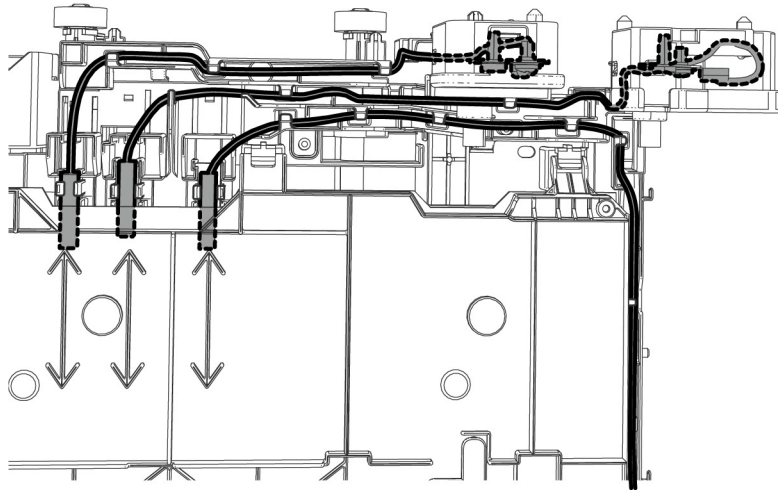
s6510_6515-091

Make sure to attach the faston connectors (P/J501, P/J502, T601: K 1st Supply Harness Assembly, YMC 1st Supply Harness Assembly, and Trans Supply Harness Assembly) at the initial position as shown in Figure 2.

Figure 2 Re-attaching HVPS Guide Harnesses (MFP)

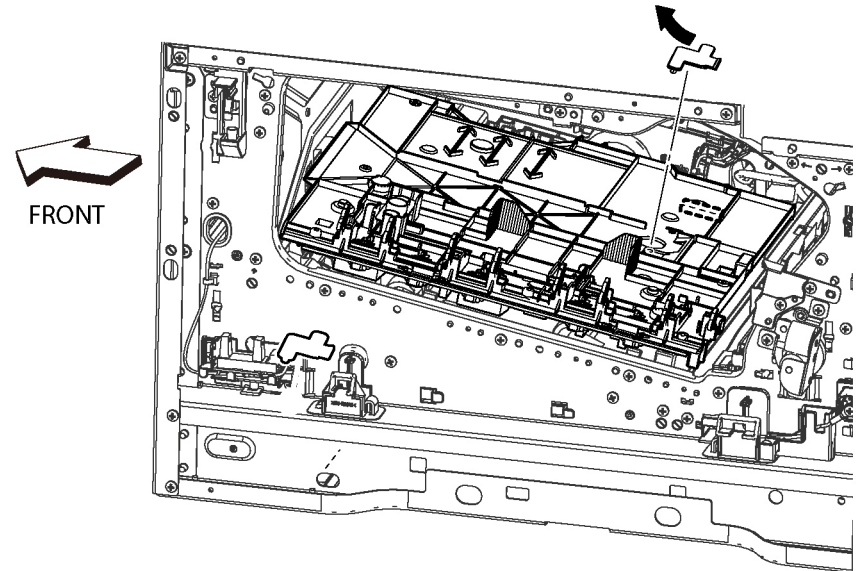
s6510_6515-439

1. Remove the Drum Cartridges Y, M, C, K, REP 8.1.1.
2. Refer to Figure 1 to remove the HVPS Toner Cover from the HVPS Board.

Figure 1 Remove the HVPS Toner Cover (MFP)

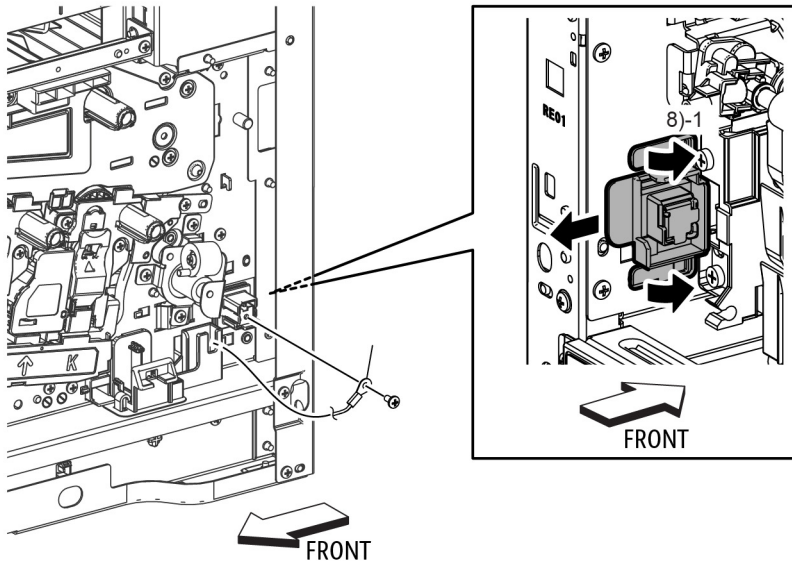
s6510_6515-092

1. Remove the Right Side Cover, REP 19.1.97.
2. Remove the Rear Cover, REP 19.2.99.
3. Refer to Figure 1 to remove the one screw (silver, M3x6mm) attaching the High Voltage Harness.

Figure 1 Remove the Second Bias Transfer Housing (MFP)

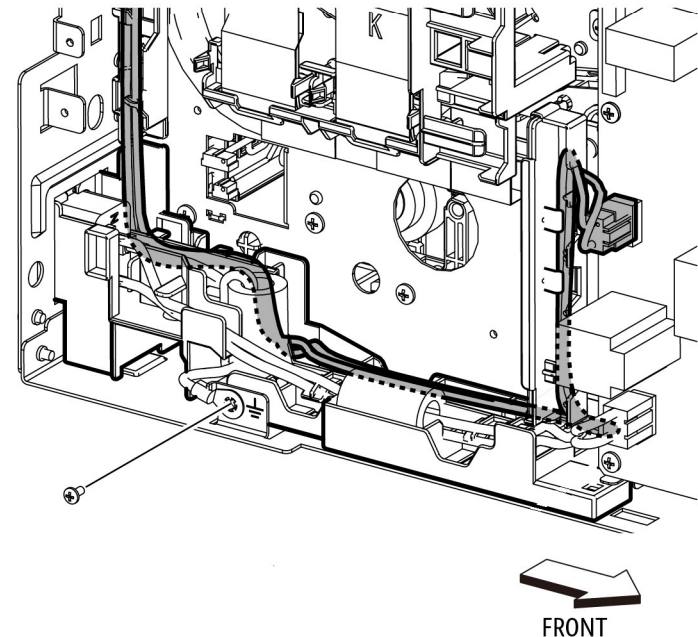
s6510_6515-093b

1. Remove the Left Side Cover, REP 19.2.1.
2. Remove the PH Drive Assembly, REP 3.1.2.
3. Refer to Figure 1 to release the AC Fuser Harness from the harness guide.
4. Refer to Figure 1 to remove the screw attaching the ground harness.

Figure 1 Remove the AC Fuser Harness (MFP)

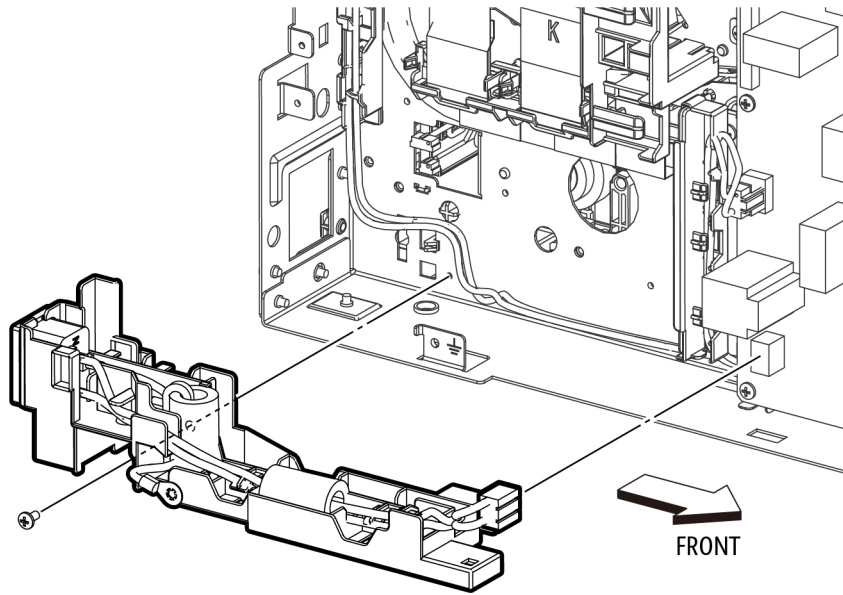
1. Remove the Left Side Cover, REP 19.2.1.
2. Remove the ESS Board, REP 18.1.5.
3. Remove the ESS Box, REP 18.1.19.
4. Refer to Figure 1 to unplug the connector (P/J292) from the LVPS Board and release the cable from the cable guide.

Figure 2 Remove the Inlet Harness Assembly (MFP)

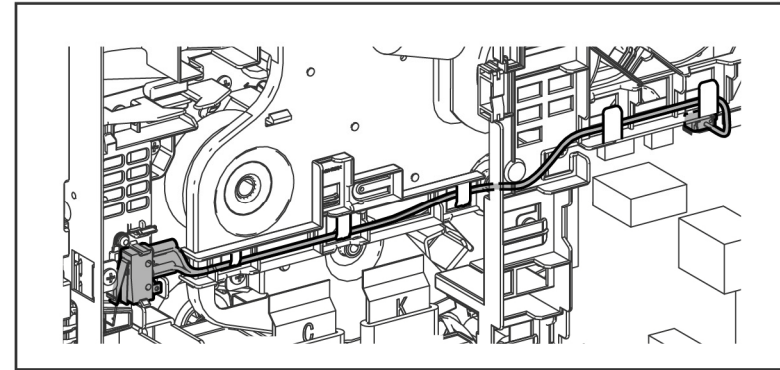
Figure 1 Remove the Rear Interlock Harness Assembly (MFP)

5. Refer to Figure 1 to release the two hooks and remove the Rear Interlock Harness Assembly.

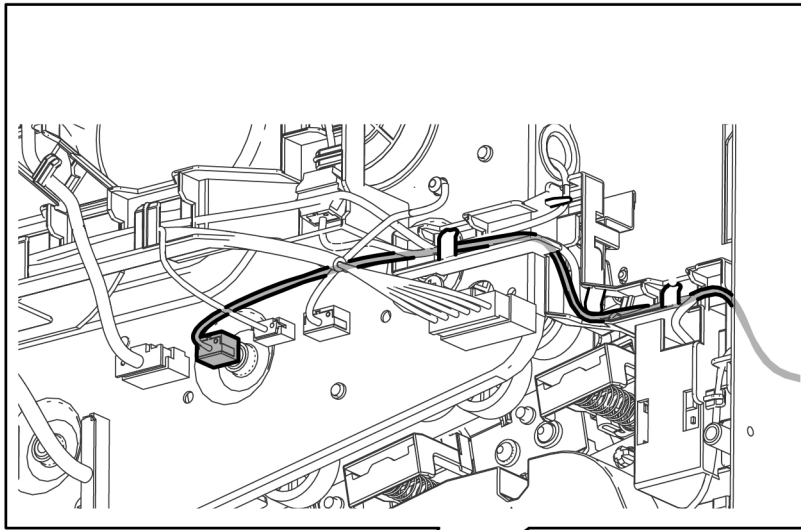
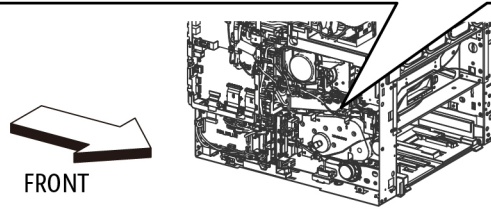
s6510_6515-096

4. Remove the Main Fan, REP 4.1.1.
5. Remove the LVPS Board, REP 18.1.16.
6. Remove the LVPS Plate, REP 18.1.20.
7. Remove the Main Fan Duct, REP 4.1.2.
8. Refer to Figure 1 to release the harness of the Side Interlock Harness Assembly from the three hooks.

Figure 1 Release the Side Interlock Harness from the Hooks

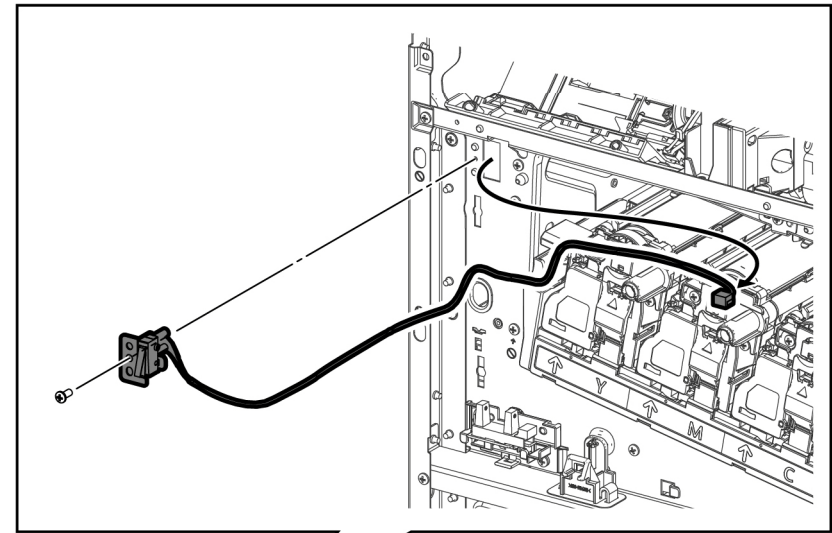
s6510_6515-097

9. Refer to Figure 2 to remove the screw (silver, M3x6mm) attaching the Side Interlock Harness Assembly and remove the harness.

Figure 2 Remove the Side Interlock Harness Assembly (MFP)

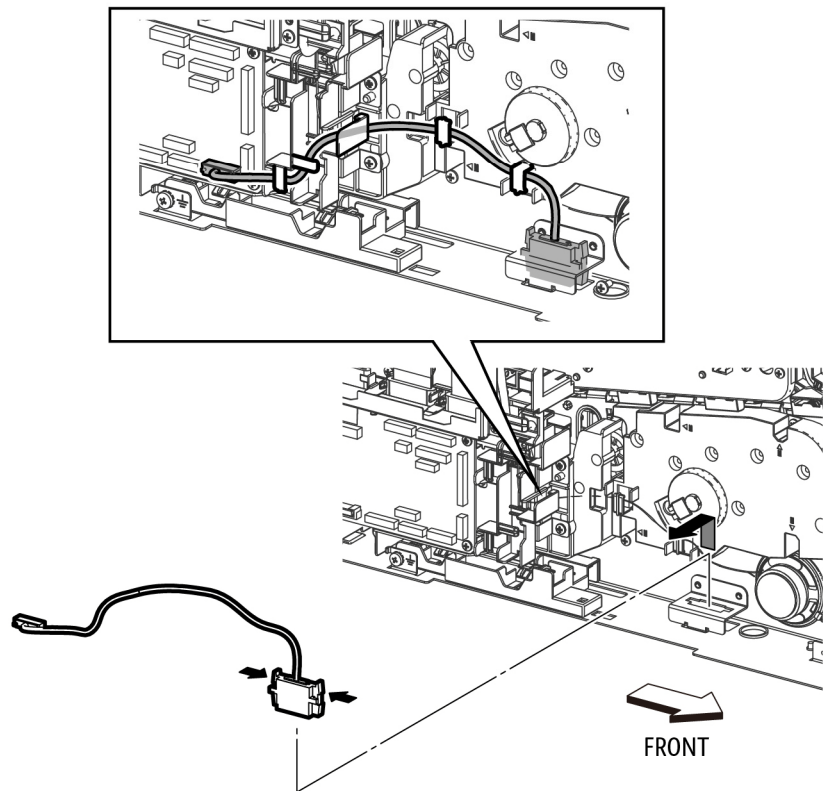
s6510_6515-098

Figure 1 Remove the OPF Harness Assembly (MFP)
