Phaser® 6510, WorkCentre® 6515 Service Manual

Xerox Phaser 6510 Color Printer/WorkCentre 6515 Color Multifunction Printer

Phaser 6510 Color Printer/WorkCentre 6515 Color Multifunction Printer Service Manual

705P01382

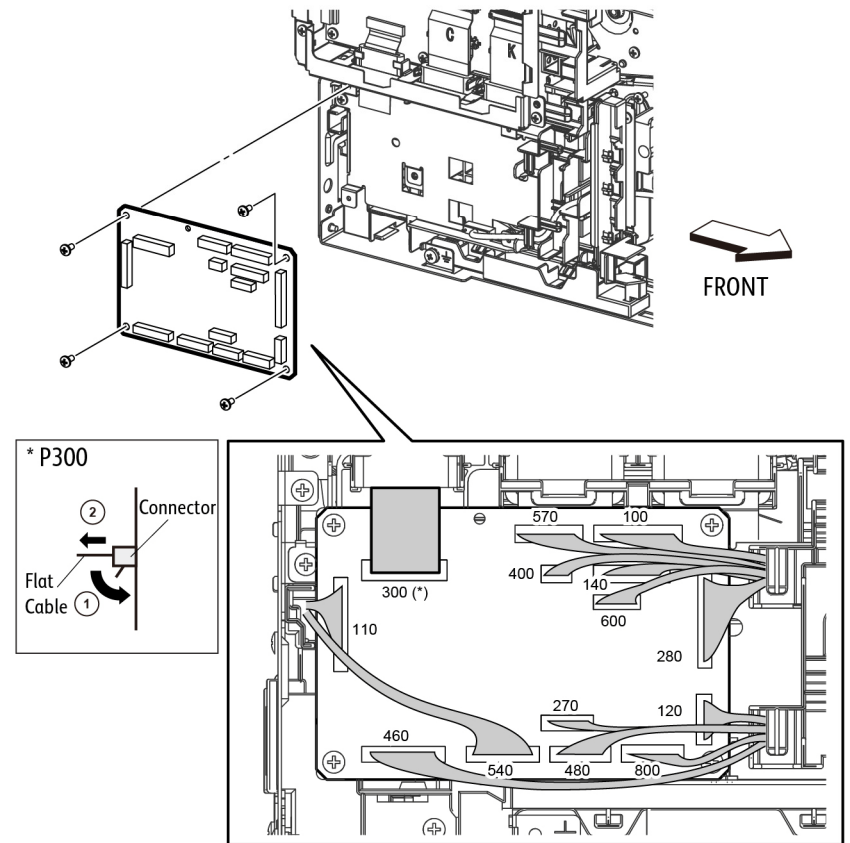
2. Refer to Figure 1 to unplug the 12 connectors from the MCU Board (P/J100, P/J110, P/J120, P/J140, P/J270, P/J280, P/J400, P/J460, P/J480, P/J540, P/J570, P/J800) and the FFC (P/J300).

Figure 1 Remove the MCU Board (SFP)

3. Refer to Figure 1 to remove the four screws (silver, M3x6mm) attaching the MCU Board and remove the board.

NOTE: In the following step, when releasing the lock lever on the FFC connector, slightly open the lock lever to 15 degrees until the lock lever contacts the FFC connector as shown in Figure 1. After releasing the lock lever, hold the lever while gently pulling the FFC from the connector.

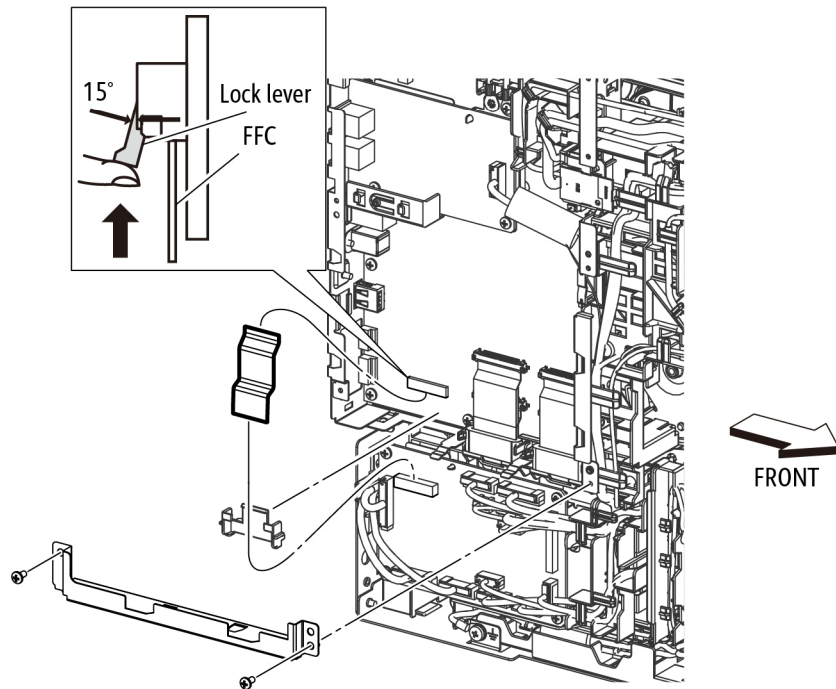
s6510_6515-081

3. Unplug the connectors (P/J300, P/J335) and remove the ESS MCU FFC.
4. Remove the MCU Color Guide FFC.

Figure 1 Remove the ESS MCU FFC (SFP)

NOTE: In the following step, when releasing the lock lever on the FFC connector, slightly open the lock lever to 15 degrees until the lock lever contacts the FFC connector as shown in Figure 1. After releasing the lock lever, hold the lever while gently pulling the FFC from the connector.

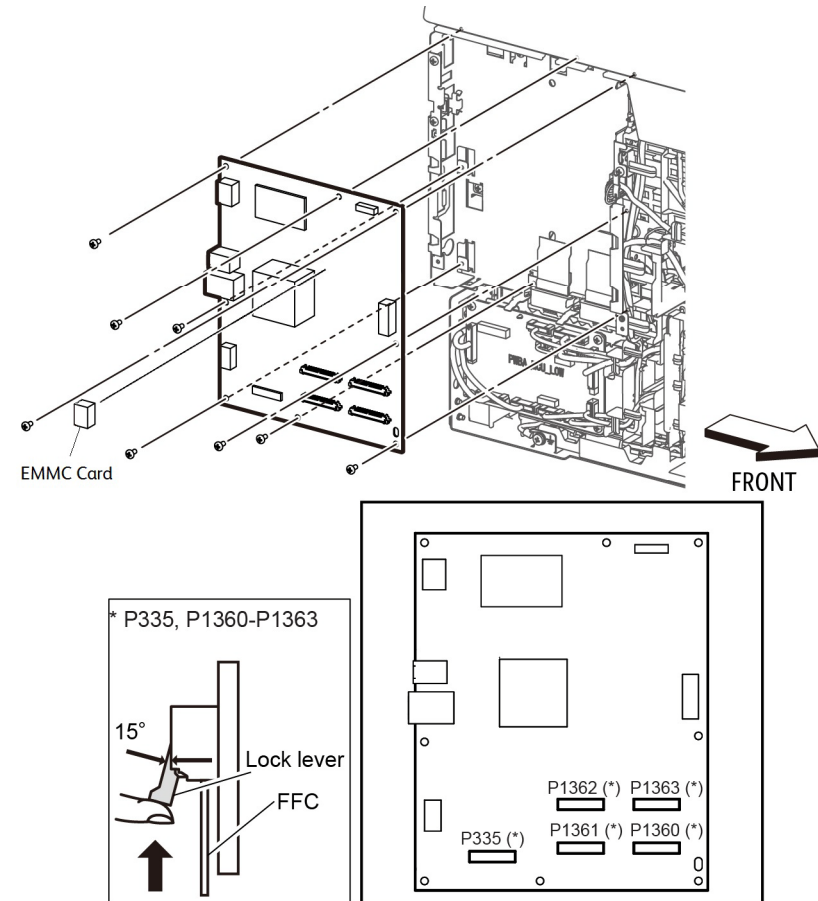
s6510_6515-099b

4. Refer to Figure 1 to unplug the FFCs (P/J1360, P/J1361, P/J1362, P/J1363, P/J335) and the connectors (P/J301, P/J353, P/J356, P/J1337, P/J1352, P/J1370, P/J1371, P/J1372, P/J1374, P/J1377). When unplugging the FFC (P/J335), keep the cable clamp open.

Figure 1 Remove the ESS Board (SFP)

NOTE: In the following step, when releasing the lock lever on the FFC connector, slightly open the lock lever to 15 degrees until the lock lever contacts the FFC connector as shown in Figure 1. After releasing the lock lever, hold the lever while gently pulling the FFC from the connector.

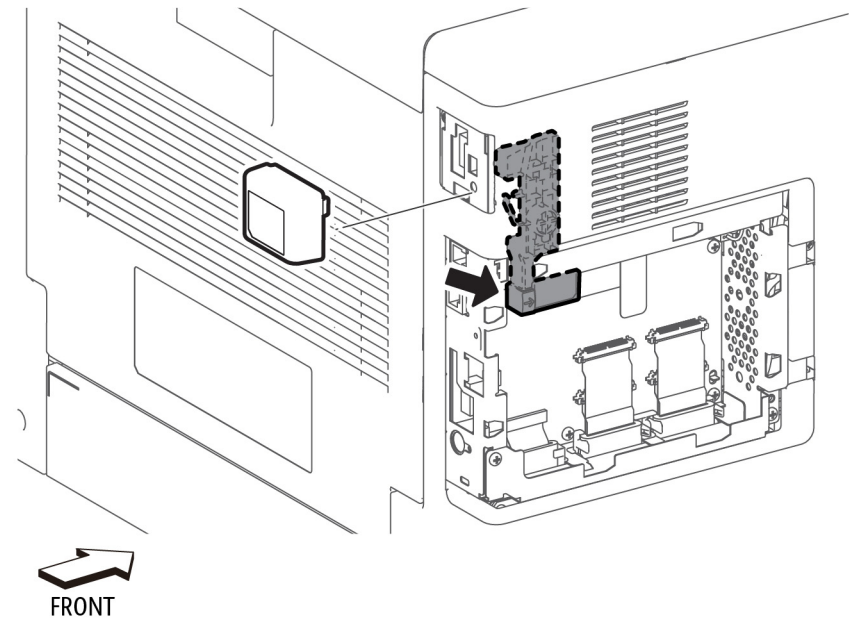
s6510_6515-100

1. Remove the ESS Window, REP 19.4.98.
2. Refer to Figure 1 to push the WIFI Link in the direction of the arrow to remove the Wireless Module.

Figure 1 Remove the WIFI Module (SFP)

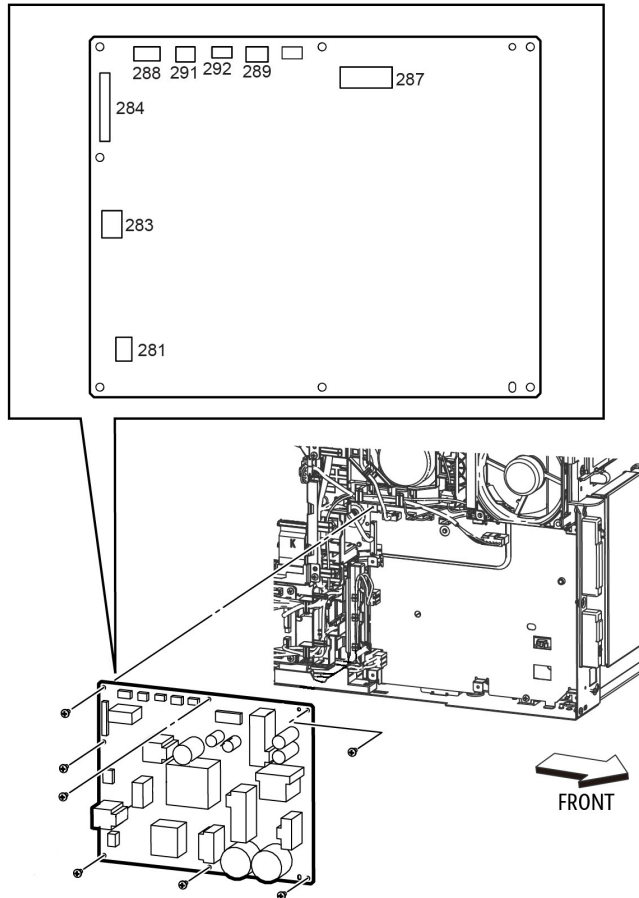
s6510_6515-086b

1. Remove the Left Side Cover, REP 19.4.1.
2. Refer to Figure 1 to unplug the connectors (P/J281, P/J283, P/J284, P/J287, P/J288, P/J289, P/J291, P/J292) from the LVPS Board.
3. Refer to Figure 1 to remove the seven screws (silver, M3x6mm) attaching the LVPS Board to the LVPS Plate.

Figure 1 Remove the LVPS Board (SFP)

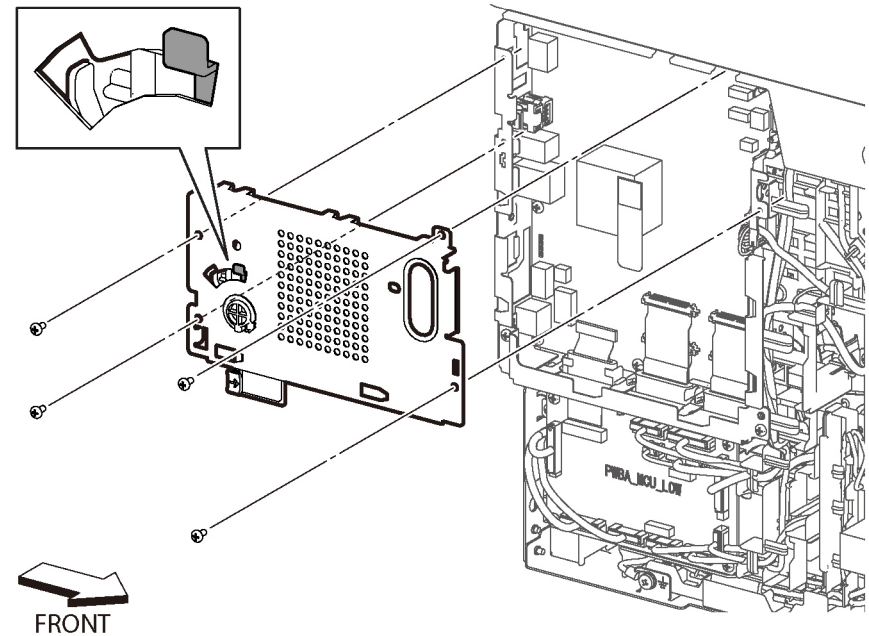
s6510_6515-127

1. Remove the Left Side Cover, REP 19.4.1.
2. Refer to Figure 1 to remove the four screws (silver, M3x6mm), and remove the ESS Top Plate with the WIFI Link.

Figure 1 Remove the ESS Top Plate (SFP)

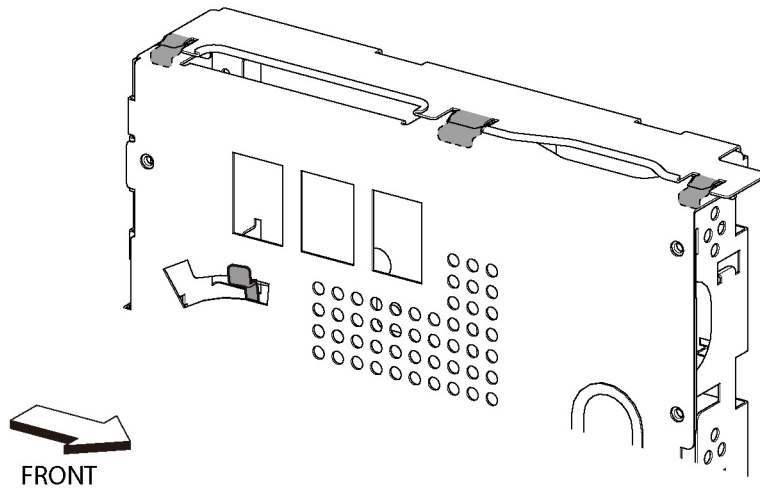
s6510_6515-088

Figure 2 Replace the ESS Top Plate

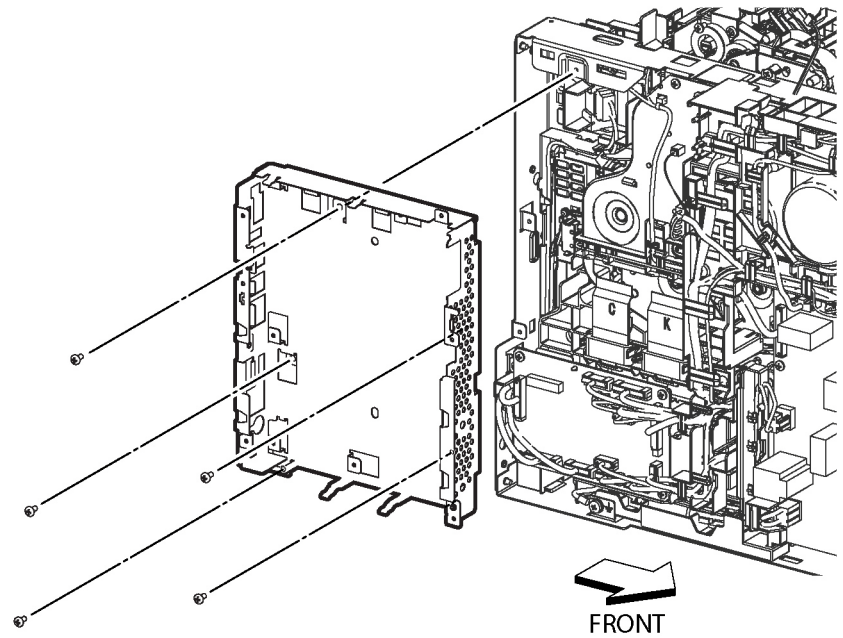
s6510_6515-128

1. Remove the Left Side Cover, REP 19.4.1.
2. Remove the ESS Board, REP 18.5.5.
3. Refer to Figure 1 to remove the five screws (silver, M3x6mm) attaching the ESS Box and remove the box.

Figure 1 Remove the ESS Box (SFP)

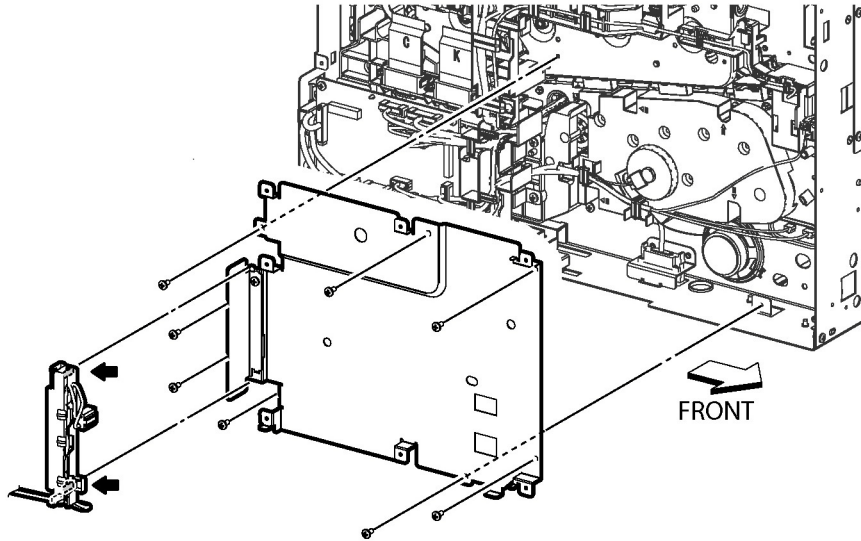
s6510_6515-129b

1. Remove the LVPS Board, REP 18.5.16.
2. Refer to Figure 1 to release the two hooks on the harness guide and remove the guide.

Figure 1 Remove the LVPS Plate

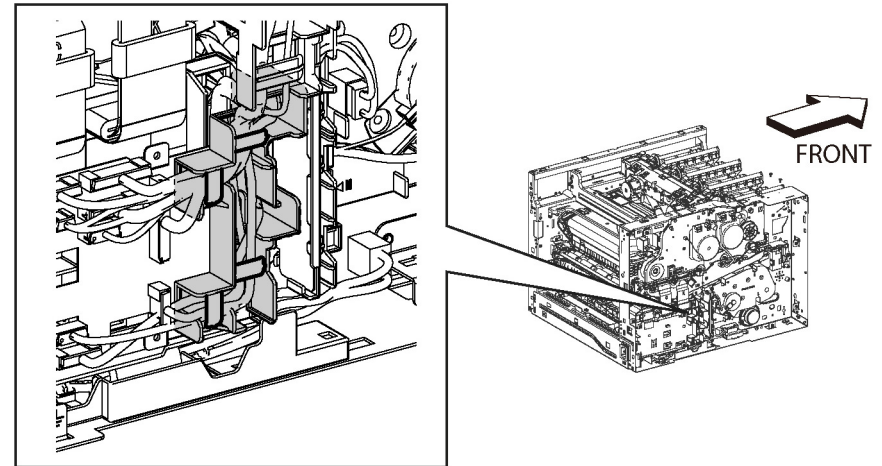
s6510_6515-125

1. Remove the Left Side Cover, REP 19.4.1.
2. Remove the MCU Board, REP 18.5.1.
3. Refer to Figure 1 to release the cables from the MCU Harness Guide and remove the guide.

Figure 1 Release the Harnesses from the MCU Plate (SFP)

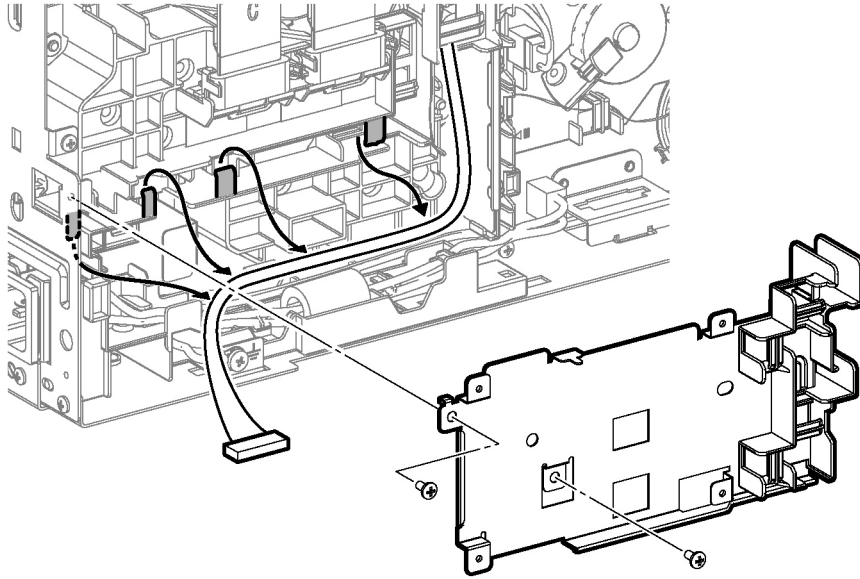
s6510_6515-126

Figure 2 Remove the MCU Plate (SFP)

When replacing the MCU Plate, place the tabs at the right edge of the plate under the tabs at the left edge of the LVPS Plate.

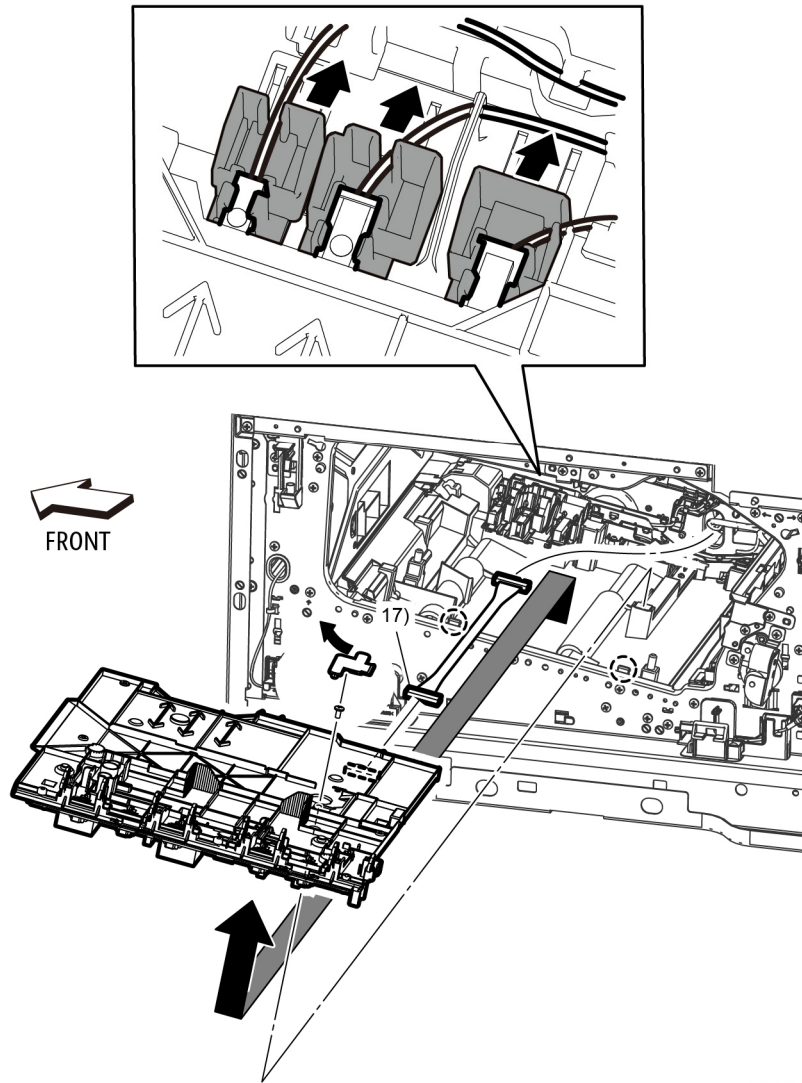
s6510_6515-090

Figure 1 Remove the HVPS Guide Assembly (SFP)

1. Connect the connector P/J101.
2. Place the HVPS Guide Assembly into its installed position making sure to insert the alignment tabs at the left edge of the board into their slots.
3. Slide the fastener connector holders towards the board to reconnect the plugs.

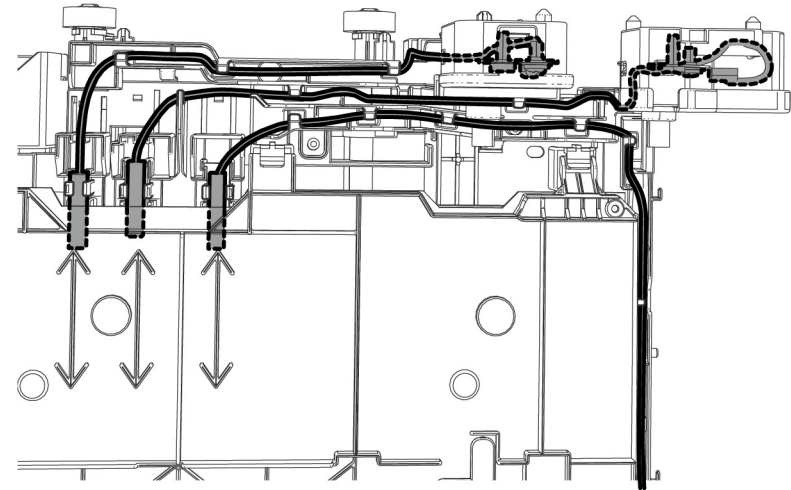
s6510_6515-091

Make sure to attach the fastener connectors (P/J501, P/J502, T601: K 1st Supply Harness Assembly, YMC 1st Supply Harness Assembly, and Trans Supply Harness Assembly) at the initial position as shown in Figure 2.

Figure 2 Re-attaching HVPS Guide Harnesses (SFP)

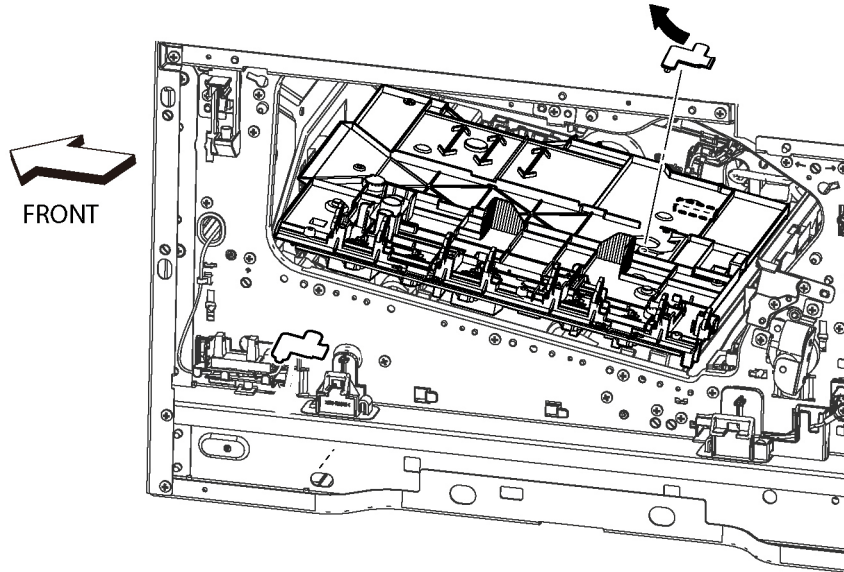
s6510_6515-439

1. Remove the Drum Cartridges Y, M, C, K, REP 8.1.1.
2. Refer to Figure 1 to remove the HVPS Toner Cover.

Figure 1 Remove the HVPS Toner Cover (SFP)

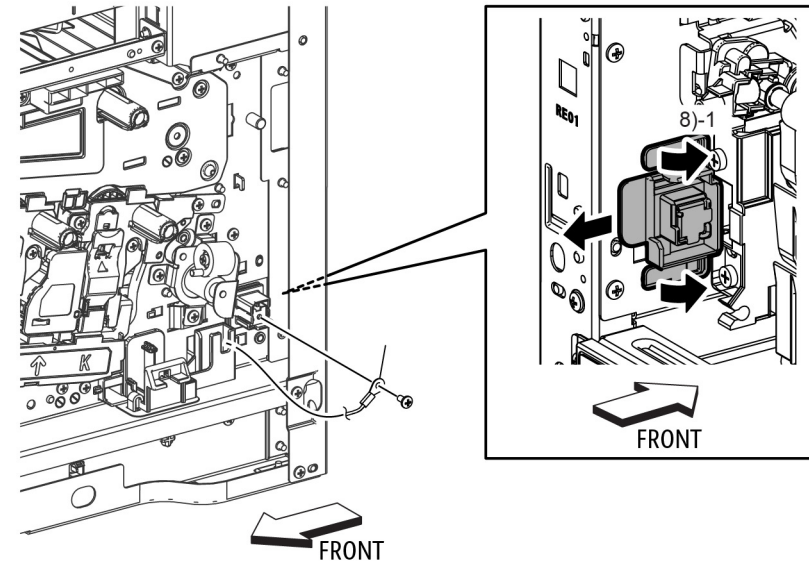
s6510_6515-092

1. Remove the Right Side Cover, REP 19.3.97.
2. Remove the Rear Cover, REP 19.4.99.
3. Refer to Figure 1 to remove the one screw (silver, M3x6mm) attaching the High Voltage Harness.

Figure 1 Remove the Second Bias Transfer Housing Kit (SFP)

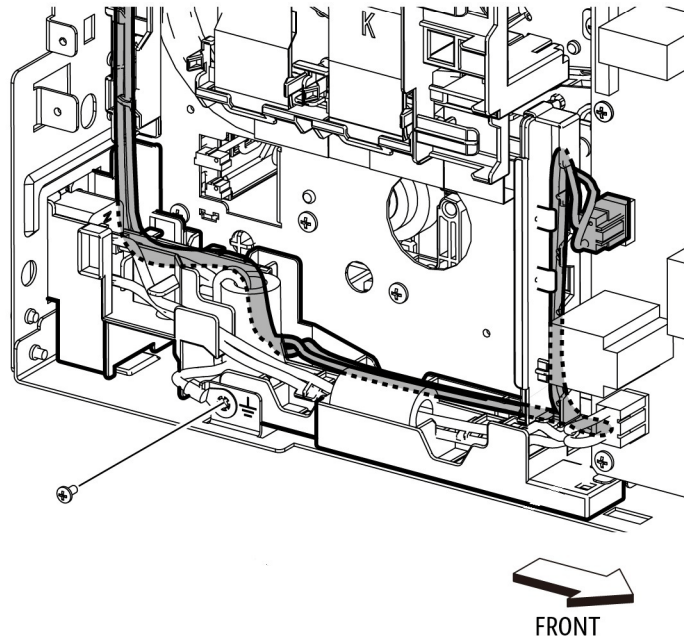
s6510_6515-093b

1. Remove the Left Side Cover, REP 19.4.1.
2. Remove the PH Drive Assembly, REP 3.1.2.
3. Refer to Figure 1 to release the AC Fuser Harness from the harness guide.
4. Refer to Figure 1 to remove the screw attaching the ground harness.

Figure 1 Release the AC Fuser and Ground Harnesses (SFP)

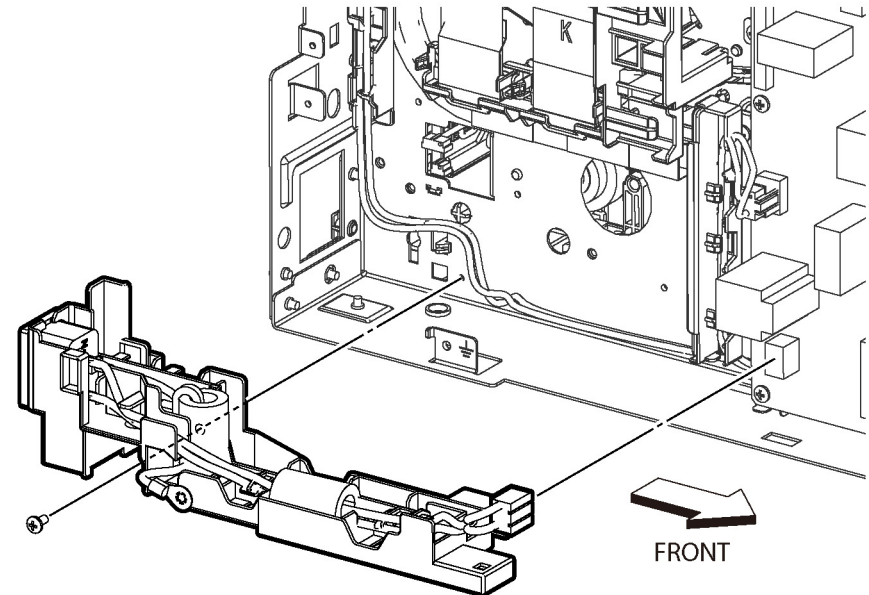
s6510_6515-131

5. Refer to Figure 2 to unplug the Inlet Harness Assembly connector (P/J281).
6. Refer to Figure 2 to remove the screw attaching the Inlet Harness Assembly and remove the harness assembly.

Figure 2 Remove the Inlet Harness Assembly (SFP)

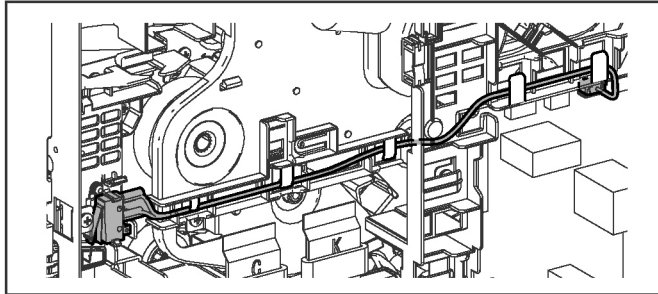
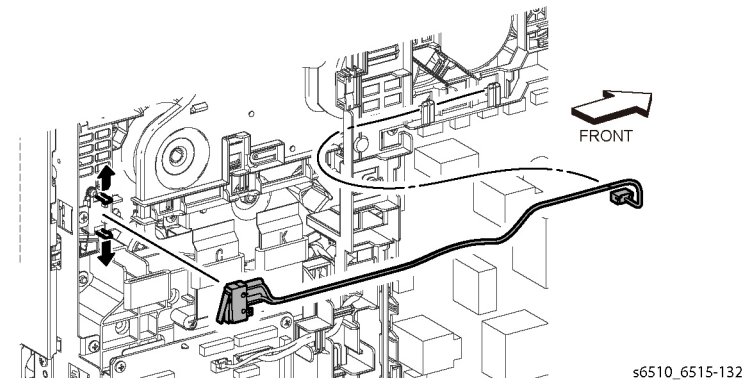
1. Remove the Left Side Cover, REP 19.4.1.
2. Remove the ESS Board, REP 18.5.5.
3. Remove the ESS Box, REP 18.5.19.
4. Refer to Figure 1 to unplug the connector (P/J292) from the LVPS Board and release the cable from the cable guide.

Figure 1 Remove the Rear Interlock Harness Assembly (SFP)

5. Refer to Figure 1 to release the two hooks and remove the Rear Interlock Harness Assembly.

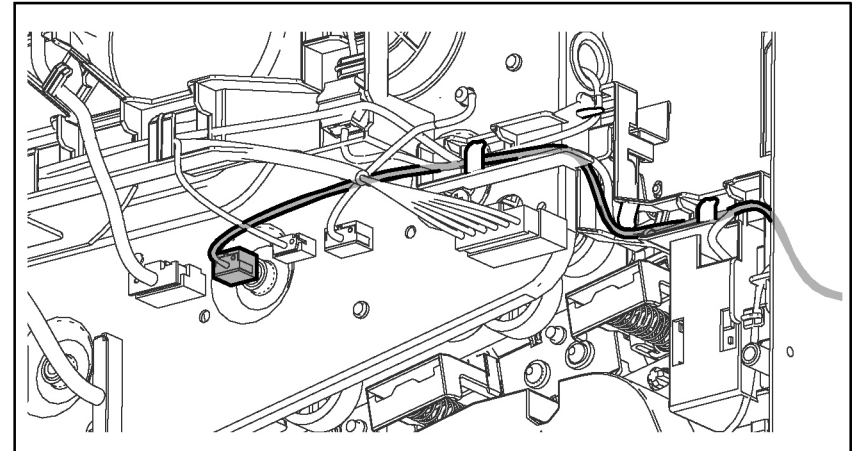
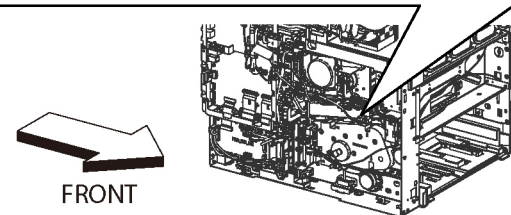
4. Remove the Main Fan, REP 4.1.1.
5. Remove the LVPS Board, REP 18.5.16.
6. Remove the LVPS Plate, REP 18.5.20.
7. Remove the Main Fan Duct, REP 4.1.2.
8. Refer to Figure 1 to release the harness of the Side Interlock Harness Assembly from the three hooks.

Figure 1 Release the Side Interlock Harness from the Hooks

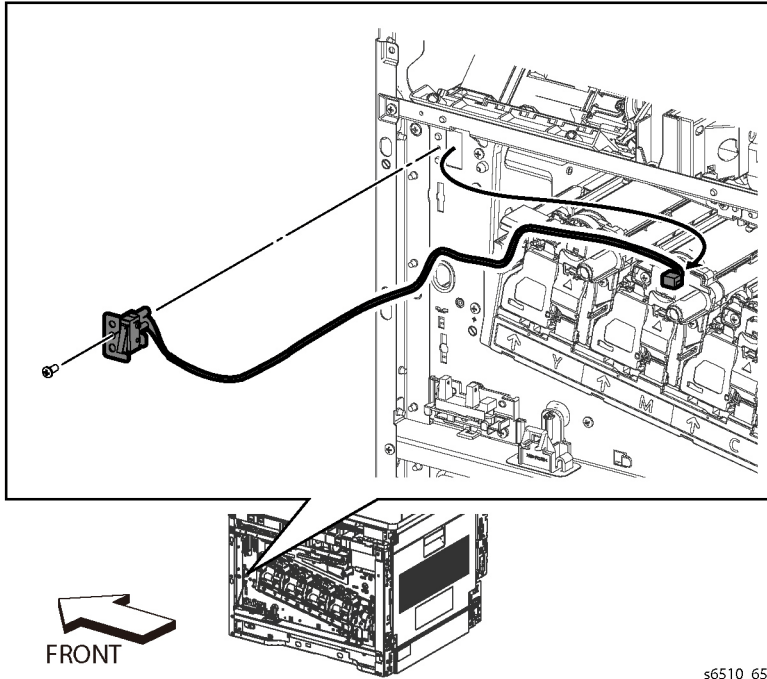
s6510_6515-134

- Refer to Figure 2 to remove the screw (silver, M3x6mm) attaching the Side Interlock Harness Assembly and remove the harness.

Figure 2 Remove the Side Interlock Harness Assembly (SFP)

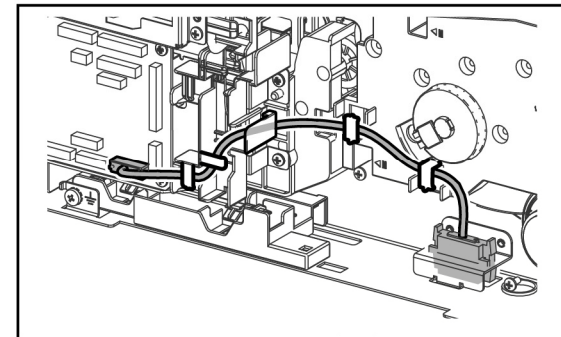
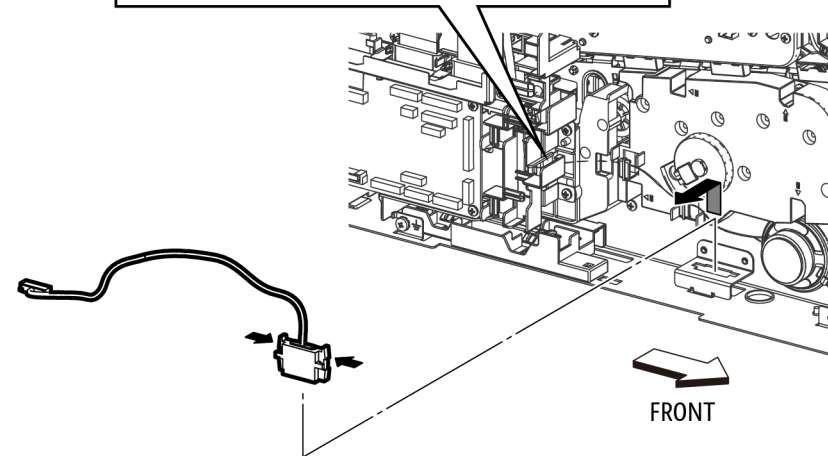
s6510_6515-098

- Remove the LVPS Board, REP 18.5.16.
- Remove the LVPS Plate, REP 18.5.20.
- Refer to Figure 1 to unplug the connector (P/J800) and release the harness portion of the OPF Harness Assembly from the four hooks of the harness guide.

Figure 1 Remove the OPF Harness Assembly (SFP)

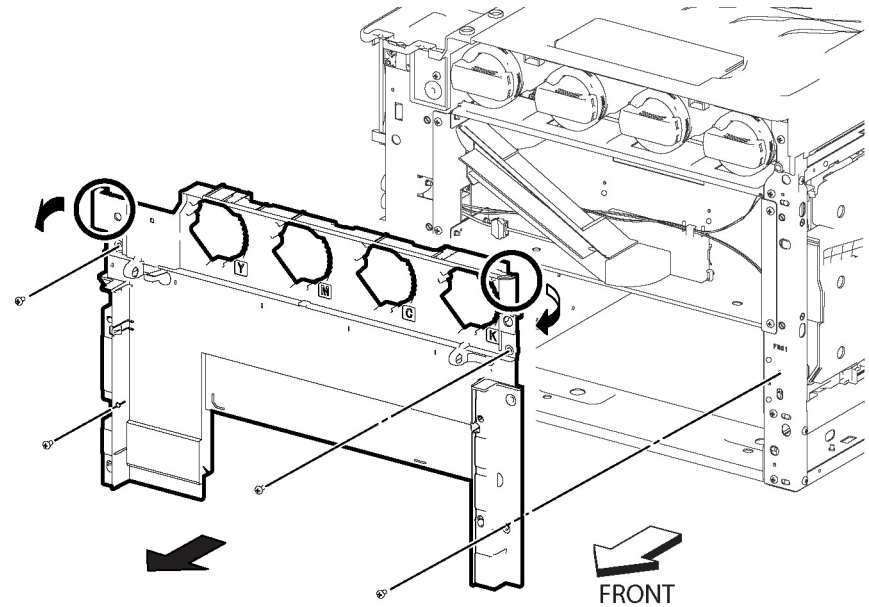
s6510_6515-135

1. Remove the Left Side Cover, REP 19.2.1.
2. Remove the Right Side Cover, REP 19.1.97.
3. Refer to Figure 1 to remove the four screws (silver, M3x6mm) attaching the Front Inner Cover.

Figure 1 Remove the Front Inner Cover (MFP)

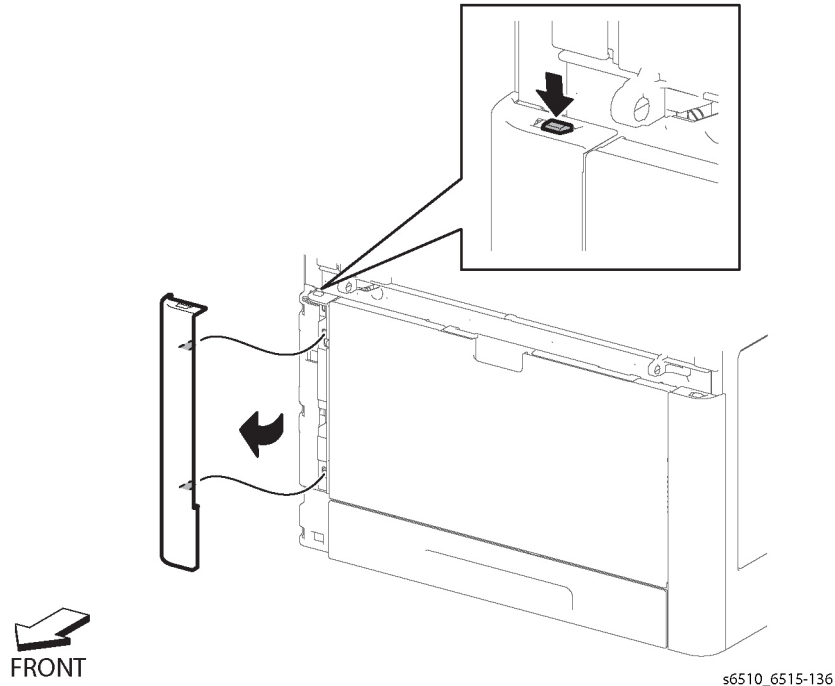
1. Remove the Toner Cover, REP 19.1.96.
2. Refer to Figure 1 to push and release the hook at the top end of the Left Side Front Cover.

Figure 1 Remove the Left Side Front Cover (MFP)

3. Release the two bosses and remove the Left Side Front Cover.

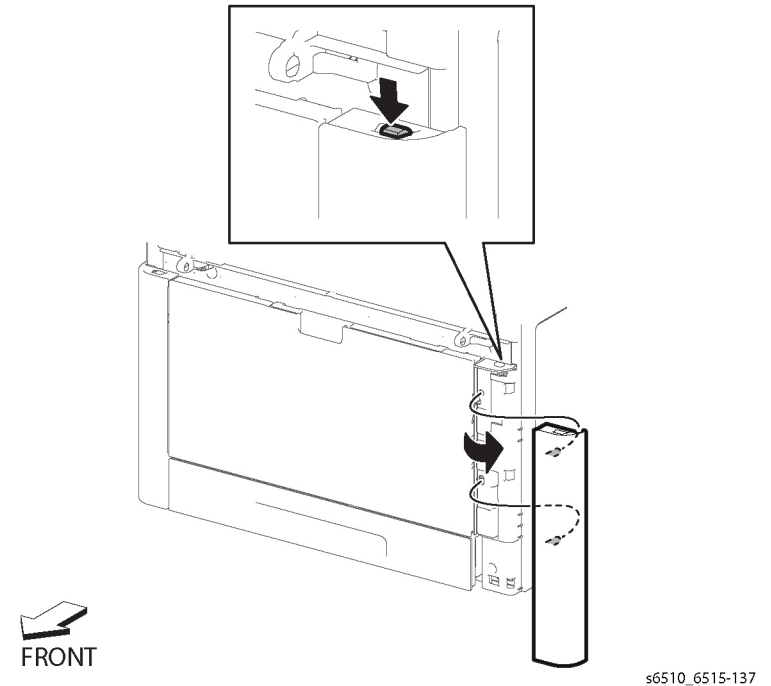
1. Remove the Toner Cover, REP 19.1.96.
2. Refer to Figure 1 to push and release the hook at the top end of the Right Side Front Cover.

Figure 1 Remove the Right Side Front Cover (MFP)

3. Release the two bosses and remove the Right Side Front Cover.

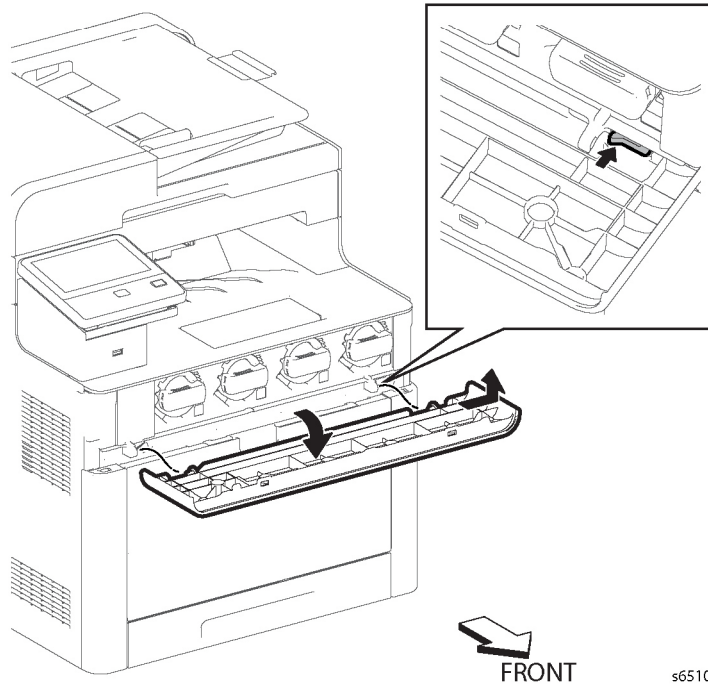
1. Open the Toner Cover Assembly.
2. Refer to Figure 1 to release the latch attaching the Toner Cover.

Figure 1 Remove the Toner Cover Assembly (MFP)

3. Remove the Toner Cover Assembly in the direction of the arrow.

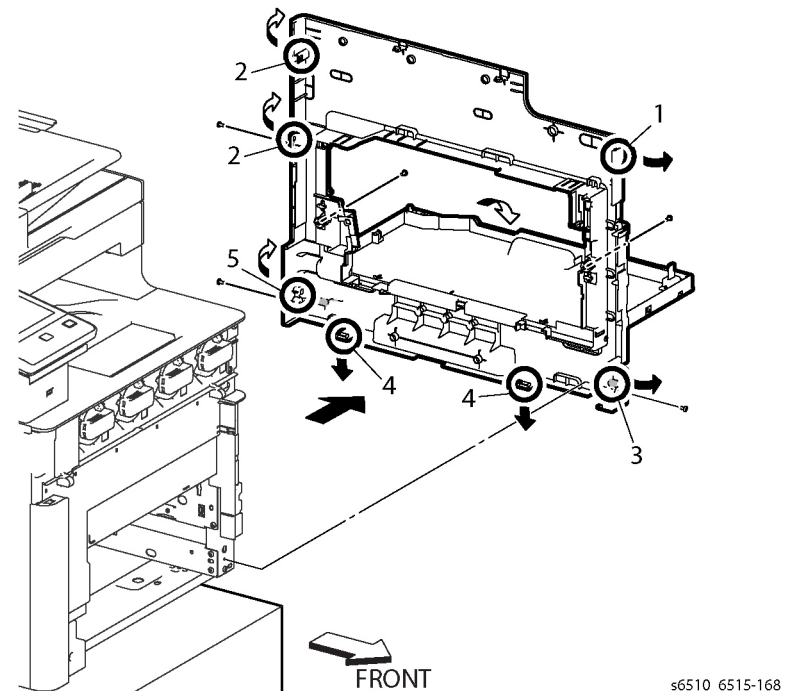
1. Separate the printer from the Option Feeder Assembly, REP 10.1.1.
2. Remove the 250 Sheet Cassette.
3. Remove the Main Bypass Tray Assembly, REP 13.2.1.
4. Remove the Toner Cover Assembly, REP 19.1.96.
5. Remove the Right Side Front Cover, REP 19.1.23.
6. Open the Waste Cover.
7. Remove the Waste Cartridge, REP 8.1.5.
8. Open the Rear Cover.
9. Refer to Figure 1 to remove the five screws (silver, M3x6mm) attaching the Right Side Cover Assembly.

Figure 1 Remove the Right Side Cover Assembly (MFP)

11. Following the sequence shown in Figure 1, release the hooks and bosses of the Right Side Cover Assembly, and remove the cover.

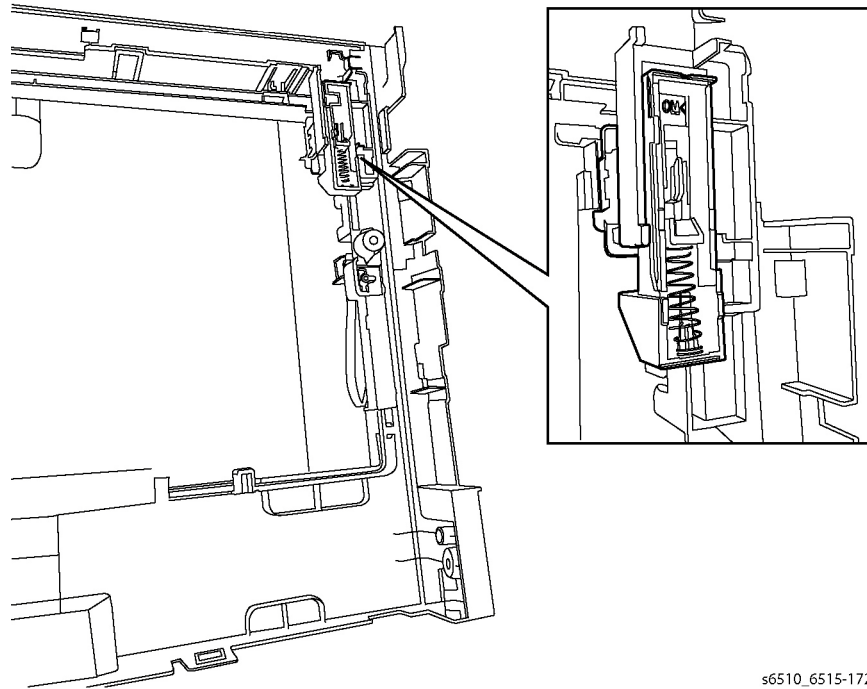
s6510_6515-172

NOTE: If the Waste Link and Waste Link Spring fall off of the Right Side Cover, see Figure 2 to re-install the link and spring.

Figure 2 Re-install the Waste Link and Spring

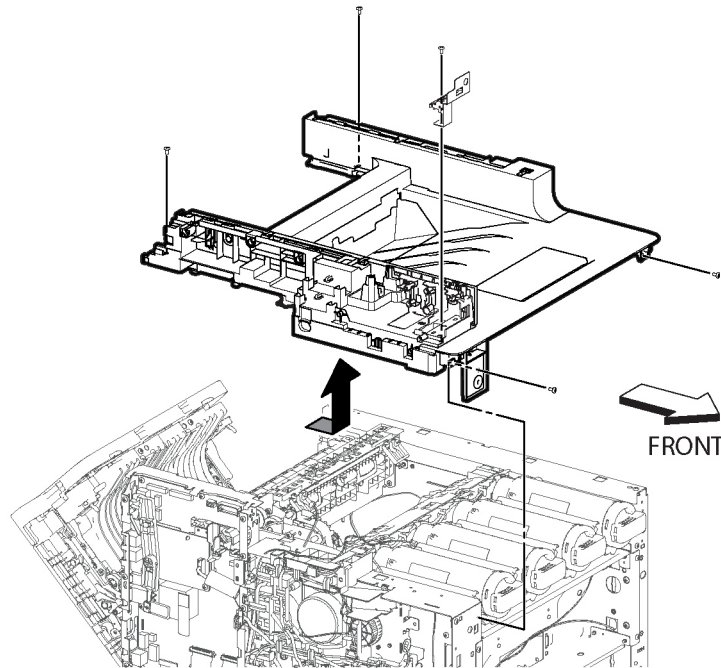
1. Remove the 250 Sheet Cassette.
2. Remove the Main Bypass Tray Assembly.
3. Remove the Right Side Cover, REP 19.1.97.
4. Remove the Left Side Cover, REP 19.2.1.
5. Remove the Front Inner Cover, REP 19.1.5.
6. Remove the ESS Top Plate, REP 18.1.18.
7. Remove the Left Side IIT Cover, REP 19.2.4.
8. Remove the UI Console Assembly, REP 1.1.1.
9. Open the Rear Cover.
10. Remove the Scanner Assembly (DADF and IIT Assemblies together), REP 50.1.13.
11. Remove the Front USB Harness Assembly, REP 18.1.14.
12. Refer to Figure 1 to remove the five screws (silver, M3x6mm) attaching the Top Cover Assembly.

Figure 1 Remove the Top Cover Assembly (MFP)

13. Slide the Top Cover towards the front of the printer, then lift the cover up.

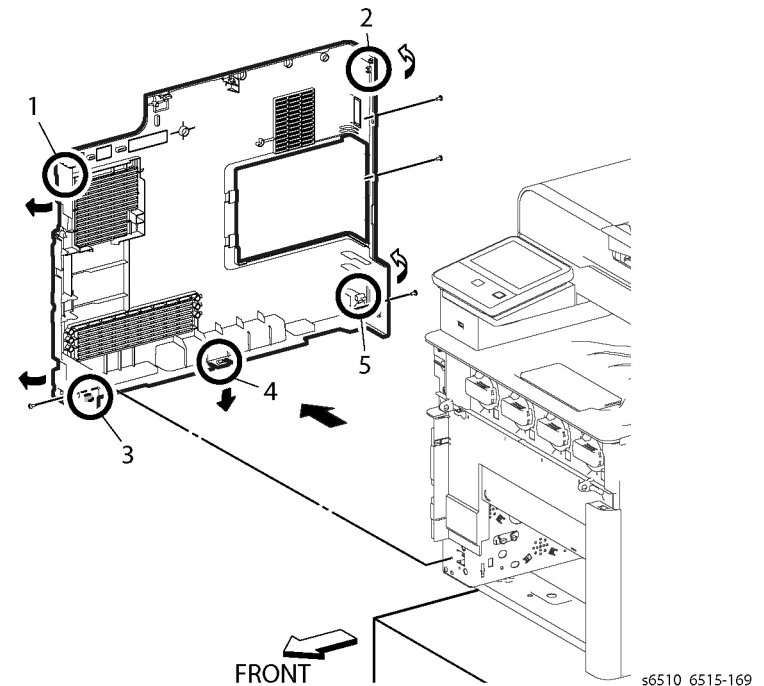
Figure 1 Remove the Left Side Cover (MFP)

1. Separate the printer from the Option Feeder Assembly, REP 10.1.1.
2. Remove the 250 Sheet Cassette.
3. Remove the Main Bypass Tray Assembly.
4. Remove the Toner Cover, REP 19.1.96.
5. Remove the ESS Window Assembly, REP 19.2.98.
6. Remove the WIFI Cap, REP 19.2.16, or the WIFI Module (if installed), REP 18.1.11.
7. Remove the Left Side Front Cover, REP 19.1.22.
8. Open the Rear Cover.
9. Refer to Figure 1 to remove the four screws (silver, M3x6mm) attaching the Left Side Cover.

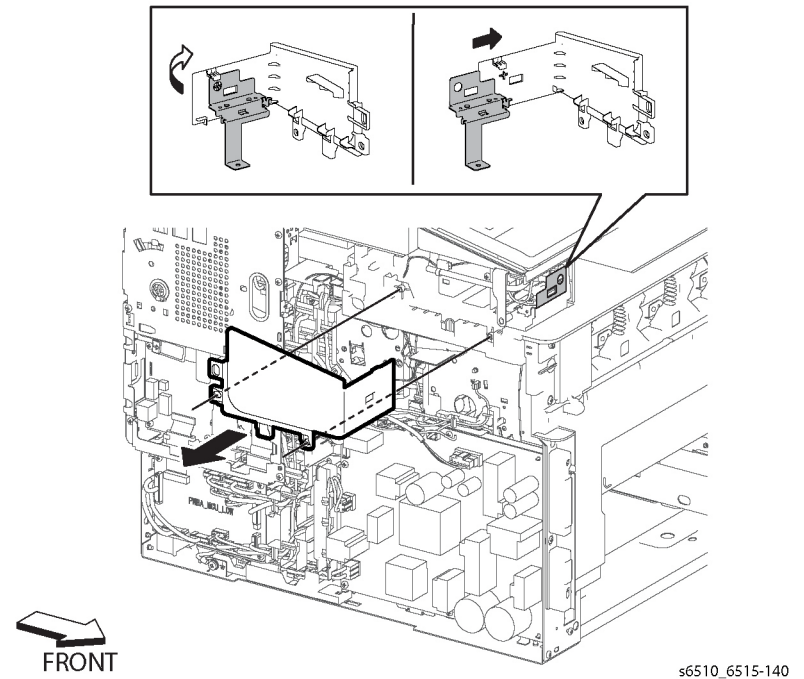
Figure 1 Remove the Left Side IIT Cover (MFP)

1. Remove the Left Side Cover, REP 19.2.1.
2. Refer to Figure 1 to slightly bend the Left Side IIT Cover in the direction of the arrow, and slide the cover to release the boss from the Bracket A.

3. Refer to Figure 1 to remove the Left Side IIT Cover in the direction of the arrow.

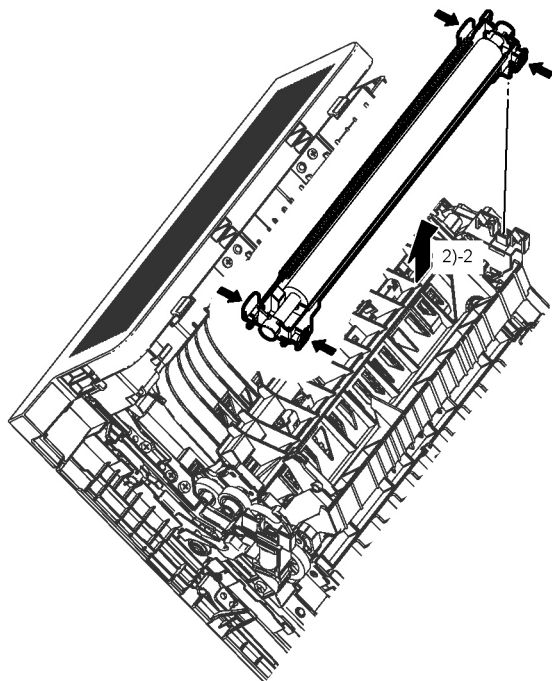
Figure 1 Remove the Second Bias Transfer Roller Assembly (MFP)

1. Open the Rear Cover.
2. Refer to Figure 1 to release the four latches attaching the Second Bias Transfer Roller and remove the roller assembly.

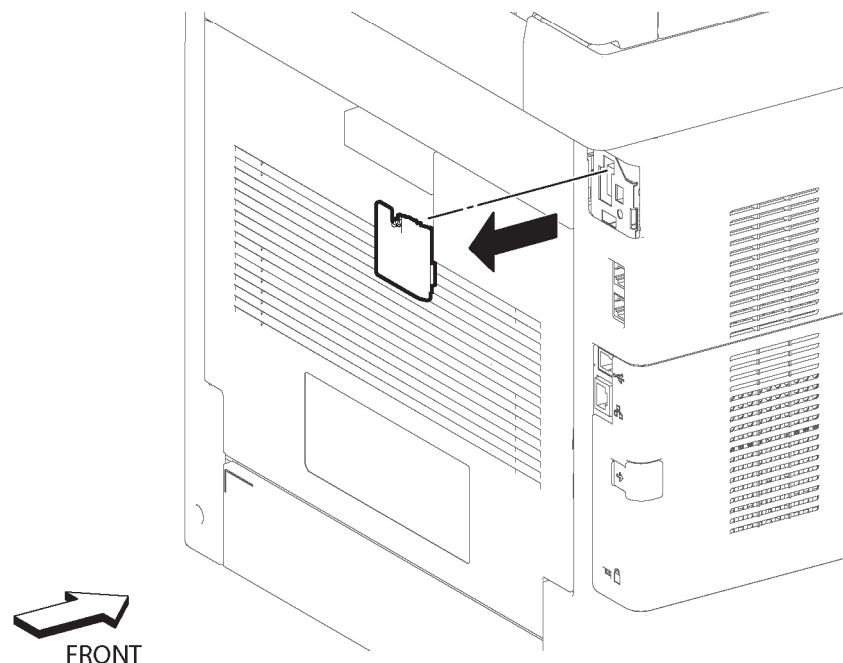
Figure 1 Remove the WIFI Cap (MFP)

1. Refer to Figure 1 to release the hook and remove the WIFI Cap.

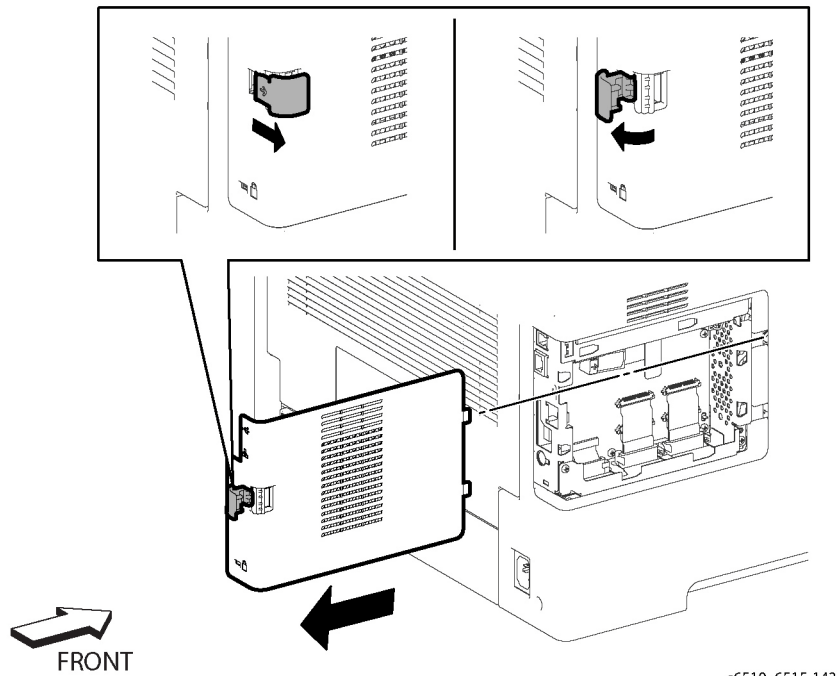
Figure 1 Remove the ESS Window Assembly (MFP)

1. Refer to Figure 1 to release the lever in the direction of the arrow.

2. Remove the ESS Window Assembly.

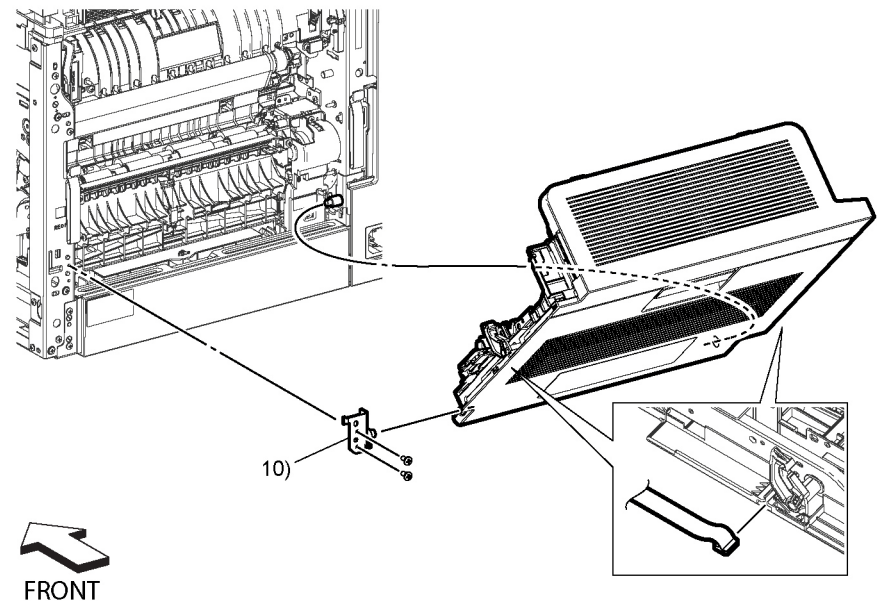
Figure 1 Remove the Rear Cover Assembly (MFP)

3. Refer to Figure 1 to remove the ends of the two Rear Cover Straps from the Rear Cover.

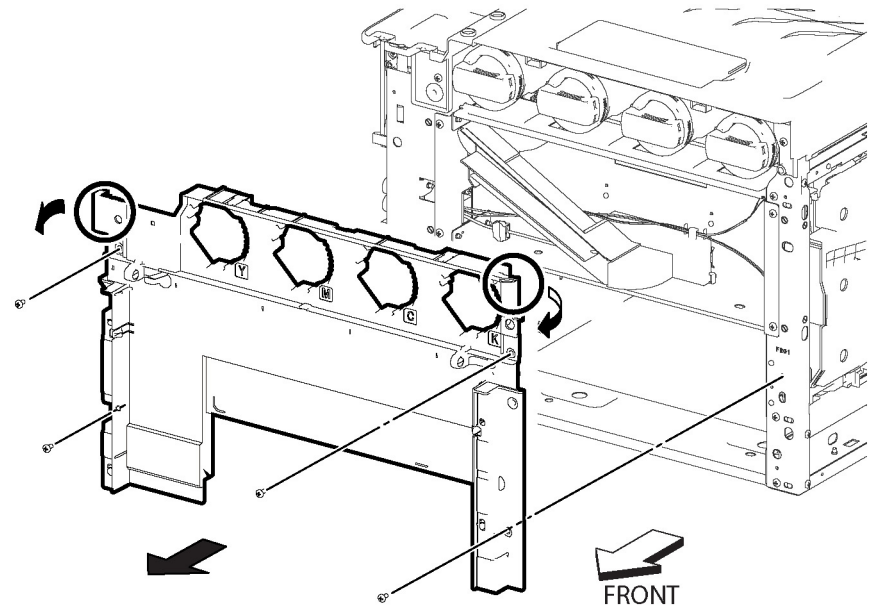
Figure 1 Remove the Front Inner Cover (SFP)

- Remove the Left Side Cover, REP 19.4.1.
- Remove the Right Side Cover, REP 19.3.97.
- Lift the front edge of the UI Console to provide clearance for the Front Inner Cover.
- Refer to Figure 1 to remove the four screws (silver, M3x6mm) attaching the Front Inner Cover.

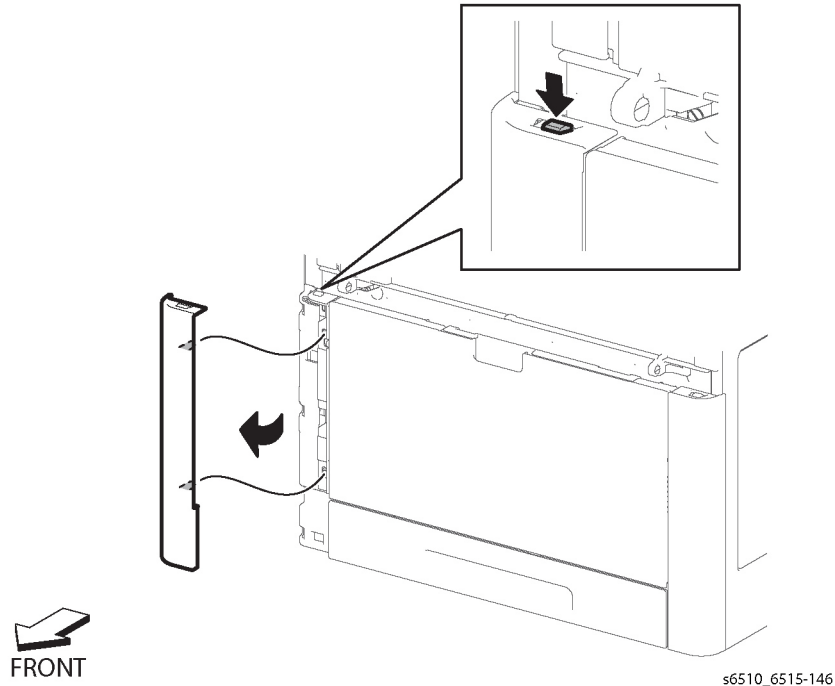
Figure 1 Remove the Left Side Front Cover (SFP)

1. Remove the Toner Cover, REP 19.3.96.
2. Refer to Figure 1 to push and release the hook at the top end of the Left Side Front Cover.

3. Release the two bosses and remove the Left Side Front Cover.

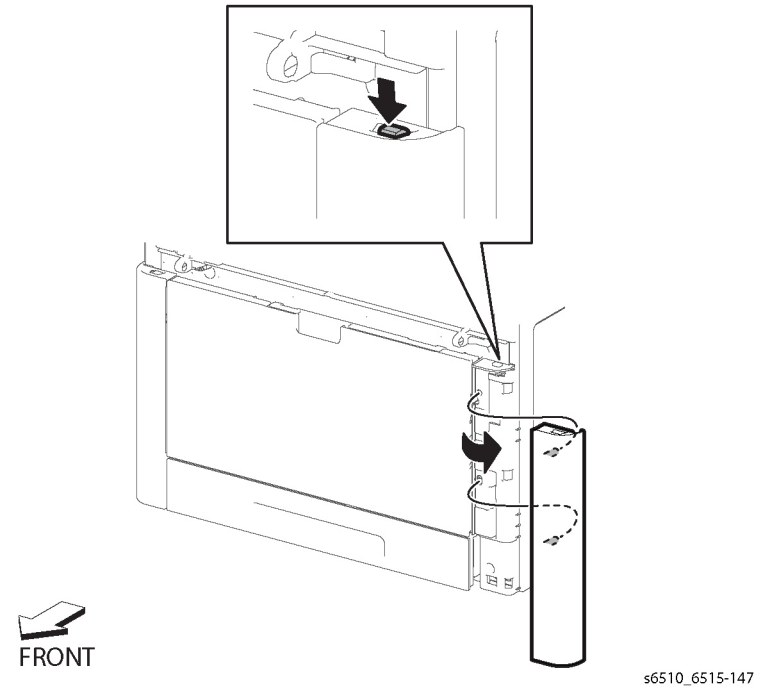
Figure 1 Remove the Right Side Front cover (SFP)

1. Remove the Toner Cover, REP 19.3.96.
2. Refer to Figure 1 to push and release the hook at the top end of the Right Side Front Cover.

3. Release the two bosses and remove the Right Side Front Cover.
