Phaser® 6510, WorkCentre® 6515 Service Manual

Xerox Phaser 6510 Color Printer/WorkCentre 6515 Color Multifunction Printer

Phaser 6510 Color Printer/WorkCentre 6515 Color Multifunction Printer Service Manual

705P01382

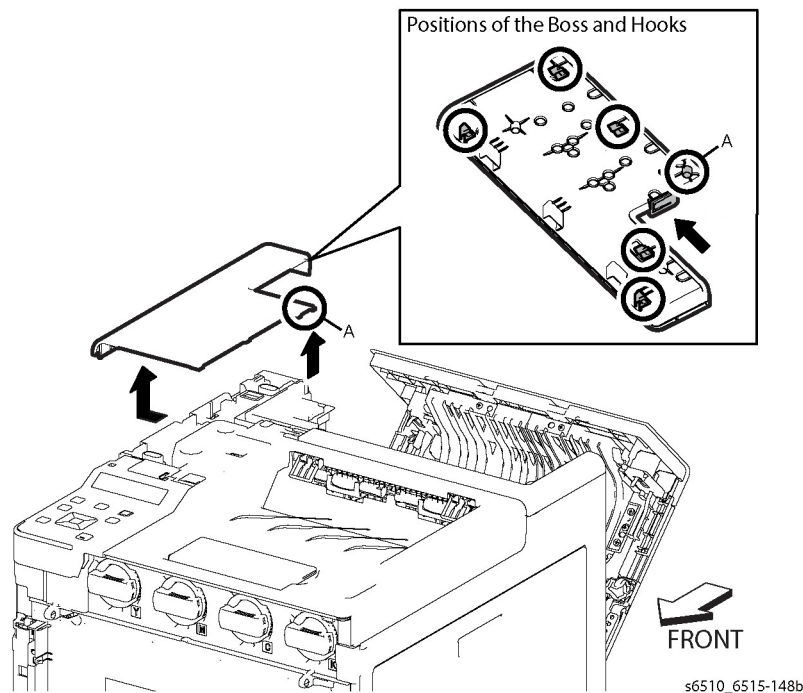
Figure 1 Remove the Left Rear Top Cover (SFP)

1. Remove the Wireless Module, REP 18.5.11, or the WIFI Cap, REP 19.4.16.
2. Open the Rear Cover.
3. Remove only the top two screws from the rear of the Left Side Cover, and release the boss at the corner of the cover. (Do not remove the cover.)
4. Refer to Figure 1 to release the boss at point A, the top rear corner of the Left Rear Top Cover, to loosen the corner from the printer chassis.

5. Refer to Figure 1 to release Latch A and slide the cover in the direction of the arrow to release the other bosses on the Left Rear Top Cover.
6. Continue to move the cover in the direction of the arrow and remove the cover.

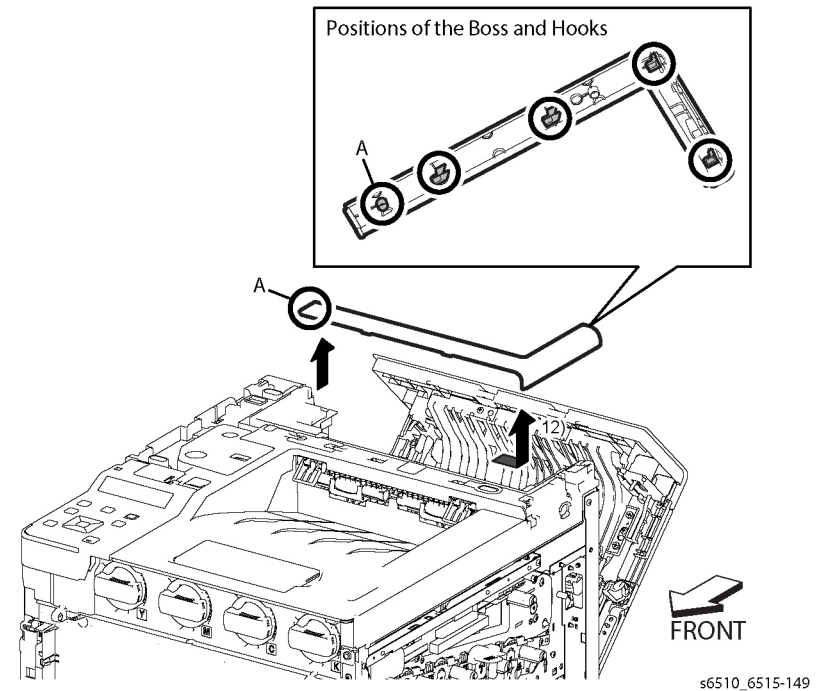
Figure 1 Remove the Right Rear Top Cover (SFP)

1. Remove the Right Side Cover, REP 19.3.97.
2. Open the Rear Cover.
3. Remove the Left Rear Top Cover, REP 19.3.24.
4. Refer to Figure 1 to release the hooks and slide the Right Rear Top Cover in the direction of the arrow.

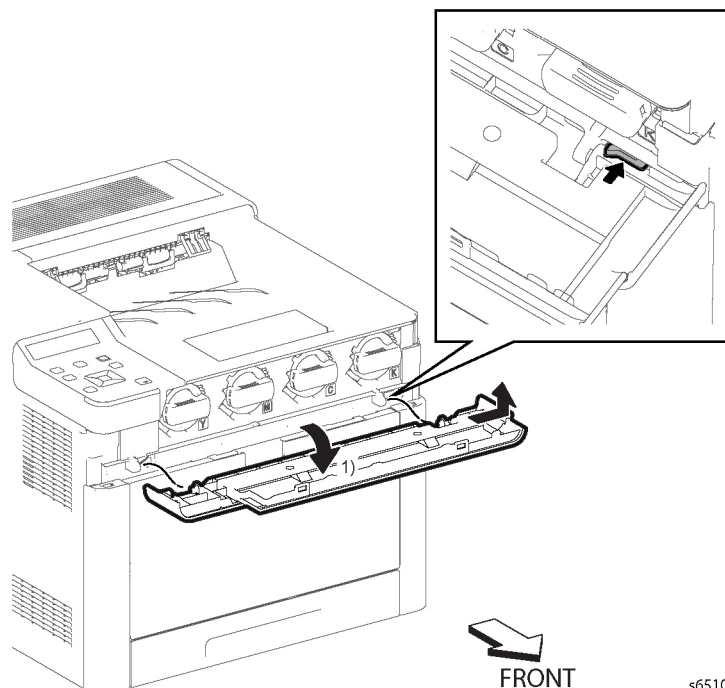
Figure 1 Remove the Toner Cover Assembly (SFP)

1. Open the Toner Cover Assembly.
2. Refer to the detail in Figure 1 to release the latch attaching the Toner Cover.

3. Remove the Toner Cover Assembly in the direction of the arrow.

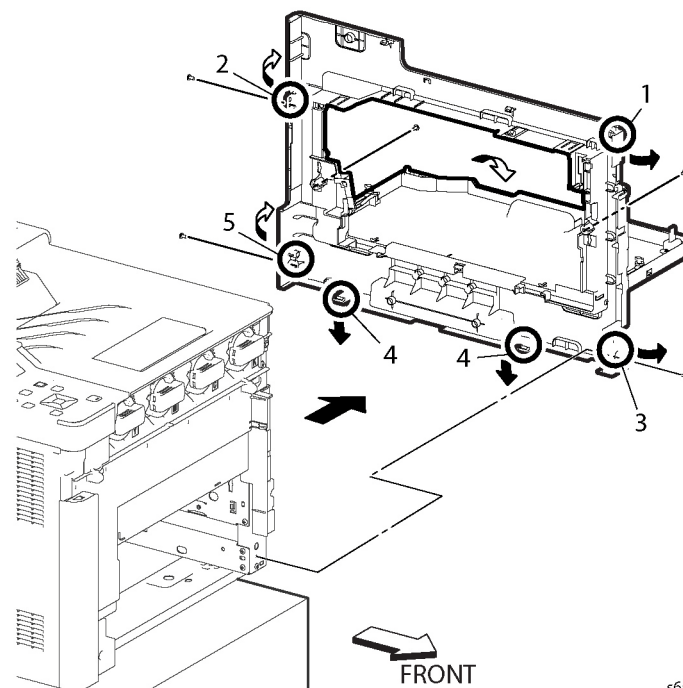
Figure 1 Remove the Right Side Cover Assembly (SFP)

1. Separate the printer from the Option Feeder Assembly, REP 10.1.1.
2. Remove the 250 Sheet Cassette.
3. Remove the Main Bypass Tray Assembly, REP 13.2.1.
4. Remove the Toner Cover Assembly, REP 19.3.96.
5. Remove the Right Side Front Cover, REP 19.3.23.
6. Open the Waste Cover.
7. Remove the Waste Cartridge, REP 8.1.5.
8. Open the Rear Cover.
9. Refer to Figure 1 to remove the five screws (silver, M3x6mm) attaching the Right Side Cover Assembly.

10. Position the right side of the printer to overhang the edge of the workbench.
11. Following the sequence shown in Figure 1, release the hooks and bosses of the Right Side Cover Assembly, and remove the cover.

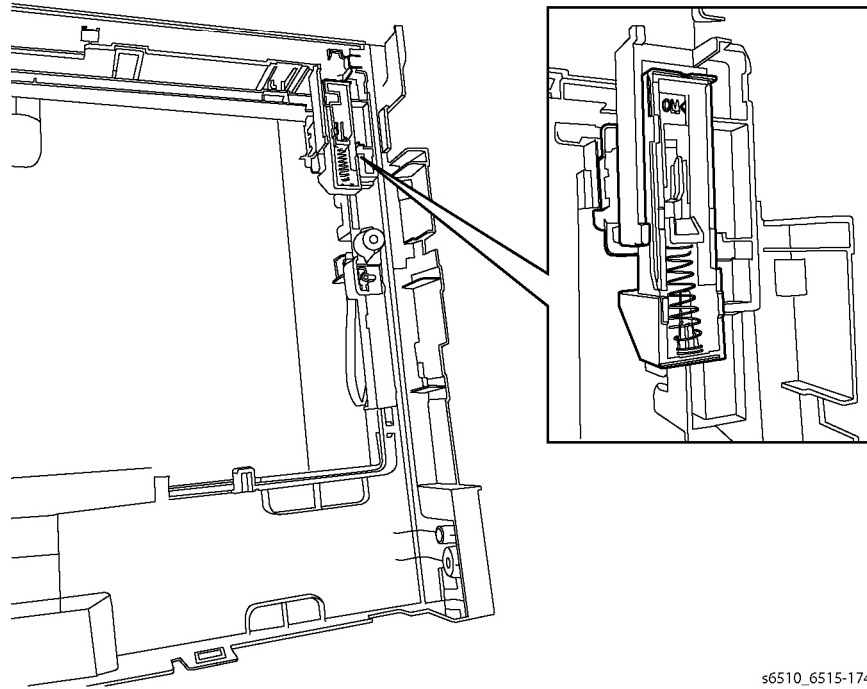
Figure 2 Re-install the Waste Link and Spring

NOTE: If the Waste Link and Waste Link Spring fall off of the Right Side Cover, see Figure 2 to re-install the link and spring.

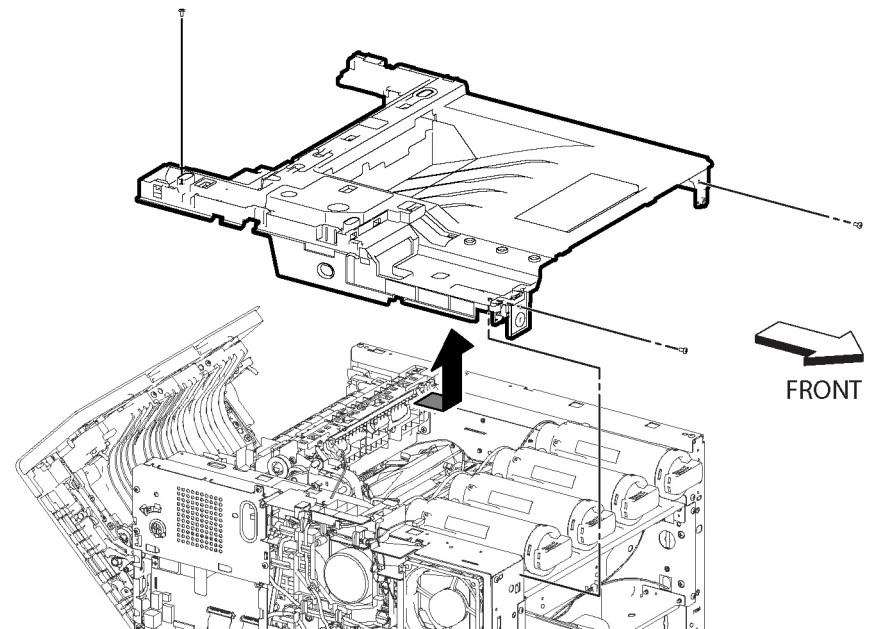
Figure 1 Remove the Top Cover Assembly (SFP)

1. Remove the 250 Sheet Cassette.
2. Remove the Main Bypass Tray Assembly.
3. Remove the Right Side Cover, REP 19.3.97.
4. Remove the Left Side Cover, REP 19.4.1.
5. Remove the Front Inner Cover, REP 19.3.5.
6. Remove the Left Rear Top Cover, REP 19.3.24.
7. Remove the Right Rear Top Cover, REP 19.3.25.
8. Open the Rear Cover.
9. Remove the UI Console, REP 1.2.1.
10. Refer to Figure 1 to remove the three screws (silver, M3x6mm) attaching the Top Cover Assembly, then lift up the cover.

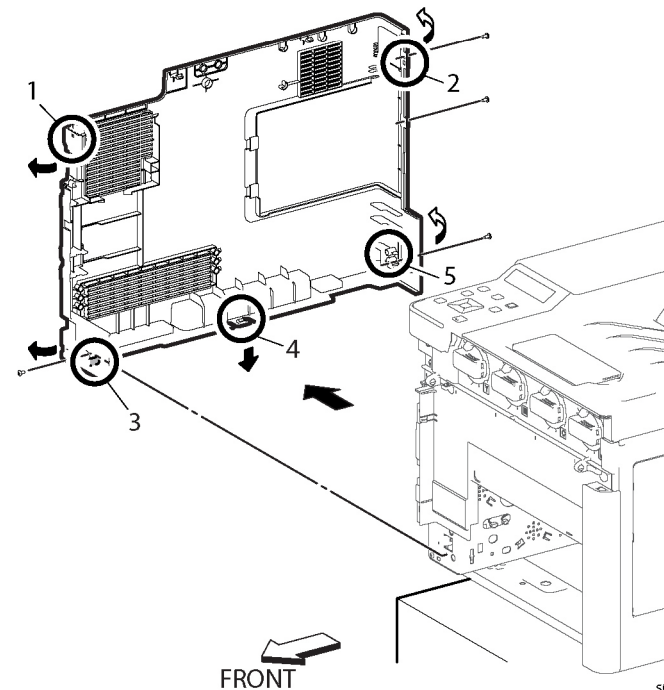
Figure 1 Remove the Left Side Cover (SFP)

1. Separate the printer from the Option Feeder Assembly, REP 10.1.1.
2. Remove the 250 Sheet Cassette.
3. Remove the Main Bypass Tray Assembly.
4. Remove the Toner Cover, REP 19.3.96.
5. Remove the ESS Window Assembly, REP 19.4.98.
6. Remove the WIFI Cap, REP 19.4.16, or the WIFI Module (if installed), REP 18.5.11.
7. Remove the Left Side Front Cover, REP 19.3.22.
8. Open the Rear Cover.
9. Refer to Figure 1 to remove the four screws (silver, M3x6mm) attaching the Left Side Cover.

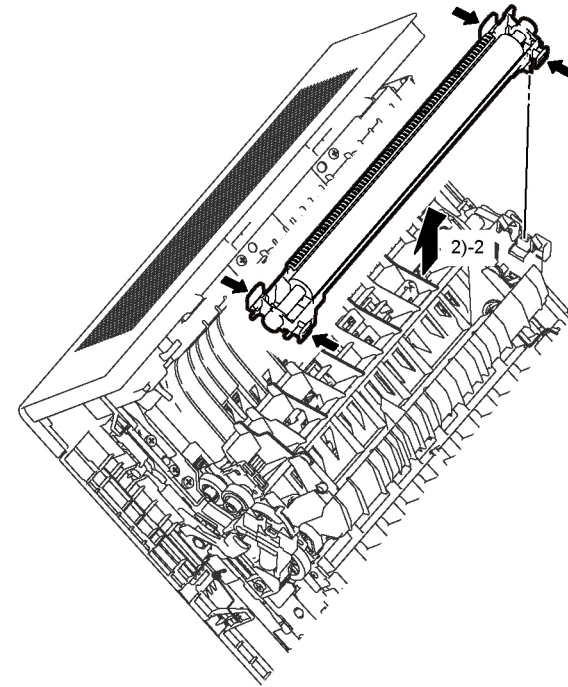
Figure 1 Remove the Second Bias Transfer Roller Assembly (SFP)

1. Open the Rear Cover.
2. Refer to Figure 1 to release the four latches attaching the Second Bias Transfer Roller and remove the roller assembly.

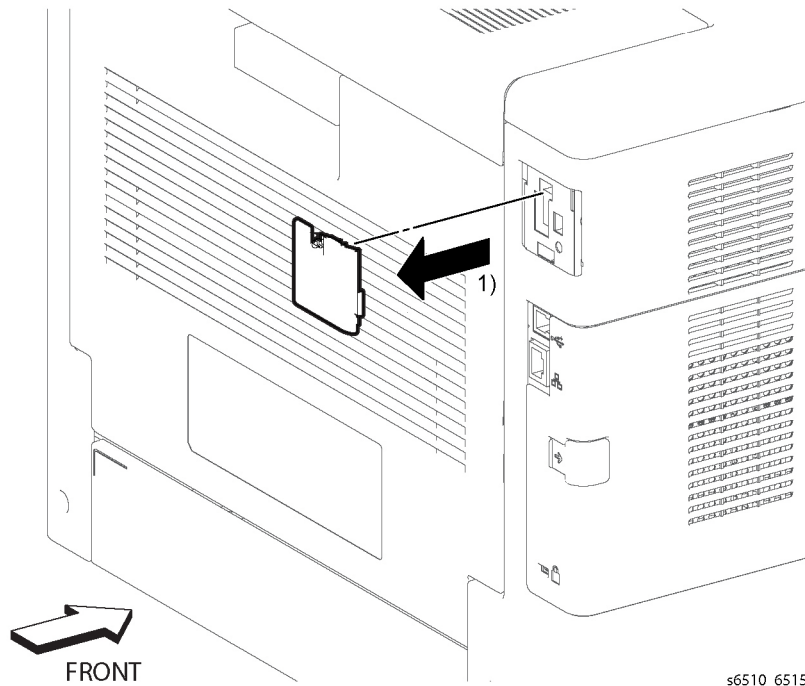
Figure 1 Remove the WIFI Cap (SFP)

1. Refer to Figure 1 to release the hook and remove the WIFI Cap.

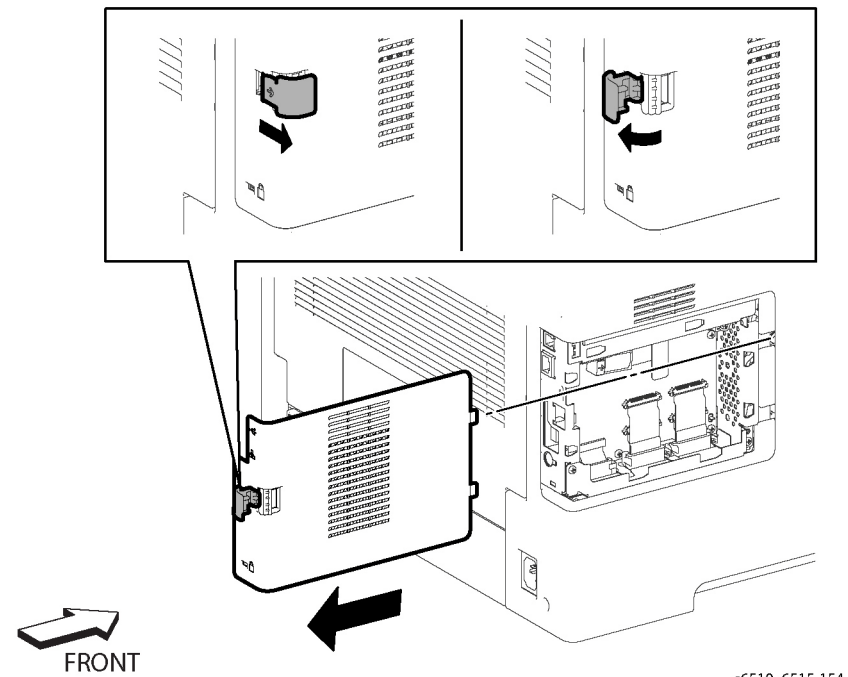
Figure 1 Remove the ESS Window Assembly (SFP)

1. Refer to Figure 1 to release the lever in the direction of the arrow.

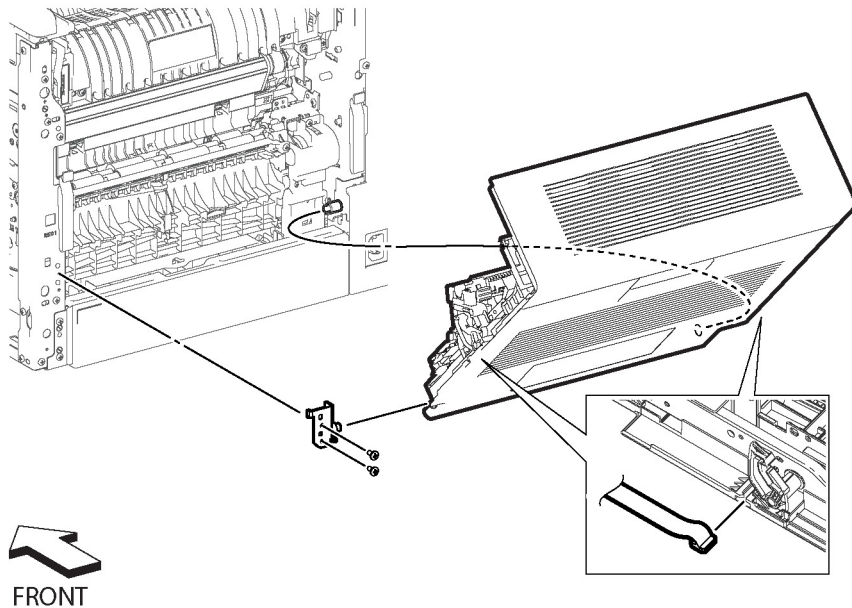
Figure 1 Remove the Rear Cover Assembly (SFP)

5. Refer to Figure 1 to remove the two screws (silver, M3x6mm) attaching the Right Rear Hinge.

6. Remove the Right Rear Hinge and the Rear Cover Assembly from the printer while opening the cover.

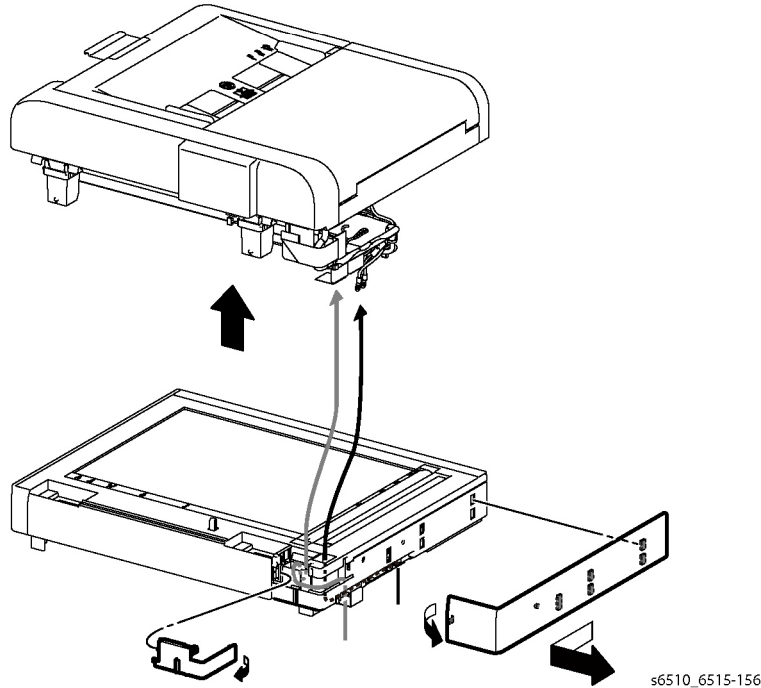
Figure 1 Remove the DADF Assembly

1. Remove the Scanner Assembly, REP 50.1.13.
2. Refer to Figure 1 to release the hook on the rear side of the Left Band Cover at the left rear corner of the IIT assembly and remove the cover in the direction of the arrow.

3. Refer to Figure 1 to release the hook and remove the FFC Cover from the IIT Assembly.
4. Refer to Figure 1 to remove the DADF harness out of its harness guide and up through the IIT Assembly.
 - a. Fold the DADF harness connector up against the wires.
 - b. Orient the harness connector to face the front of the printer.
 - c. Pass the harness up through the IIT Assembly.
5. Refer to Figure 1 to remove the DADF assembly from the IIT assembly in the direction of the arrow.

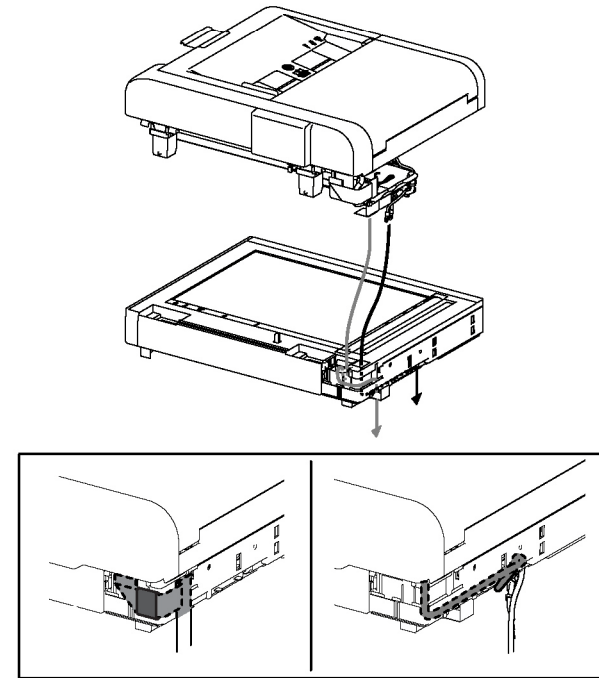
Figure 2 DADF Harness Routes

Avoid pinching wires when installing the DADF harness and FFC. Be sure to follow the harness routes as shown in Figure 2.

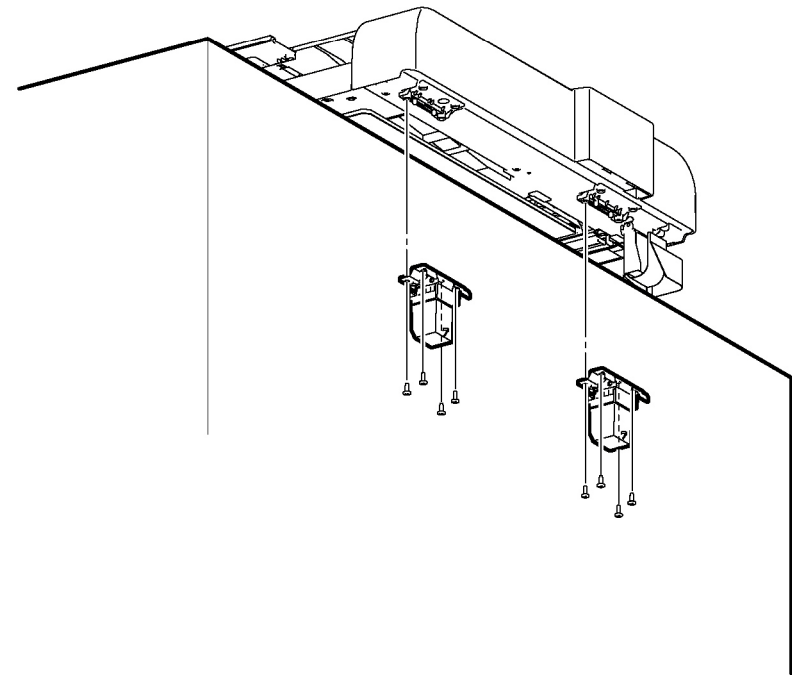
Figure 1 Remove the Hinges

1. Remove the DADF, REP 50.1.1, and refer to Figure 1 to rest the DADF on the work surface as shown.
2. Refer to Figure 1 to remove eight screws (silver, tapping, M3x8) to remove the Left and Right Hinges.

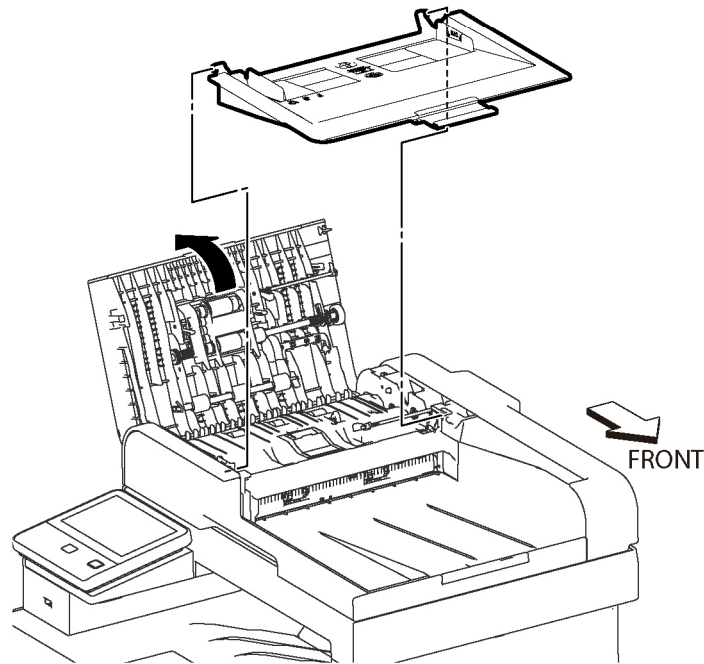
Figure 1 Remove the DADF Tray Assembly

1. Refer to Figure 1 to open the Upper Feeder Assembly.

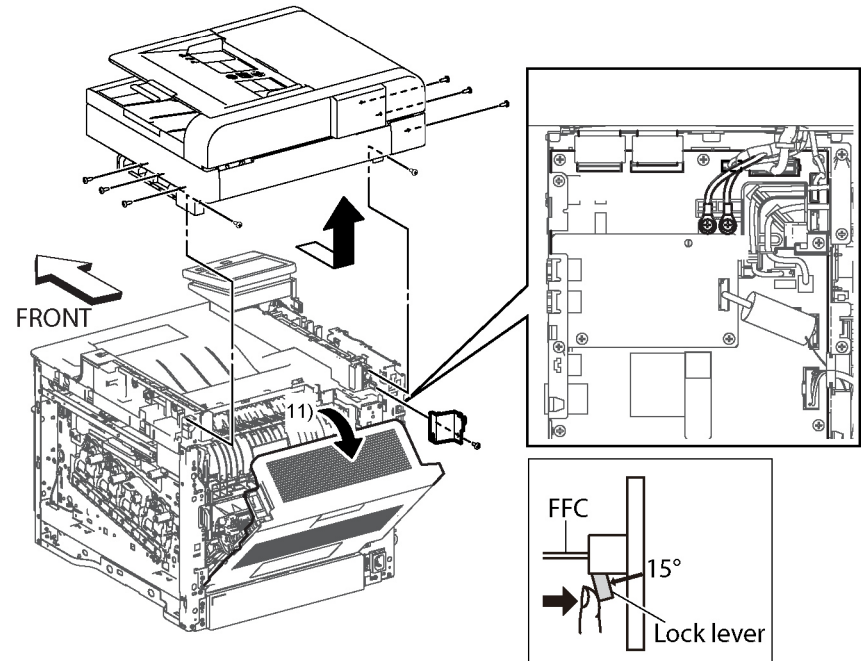
Figure 1 Disconnect Harness and Remove the Scanner Assembly

1. Remove the Right Cover Assembly, REP 19.1.97.
2. Remove the Left Cover Assembly, REP 19.2.1.
3. Remove the ESS Top Plate, REP 18.1.18.
4. Refer to Figure 1 to remove the screw (silver, tapping, M3x8) attaching the Left Rear Inner IIT Cover and remove the cover.

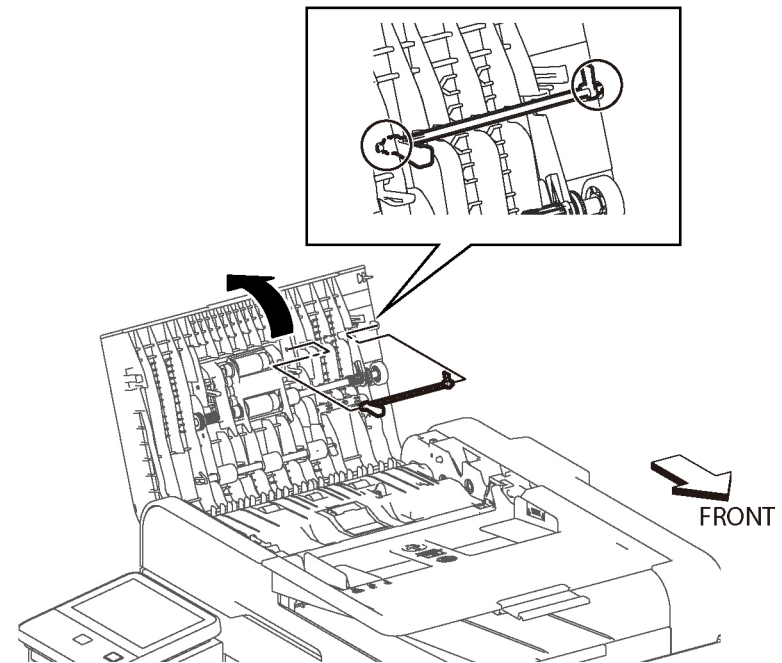
Figure 1 Remove the DADF Actuator

1. Refer to Figure 1 to open the DADF Upper Feeder Assembly.

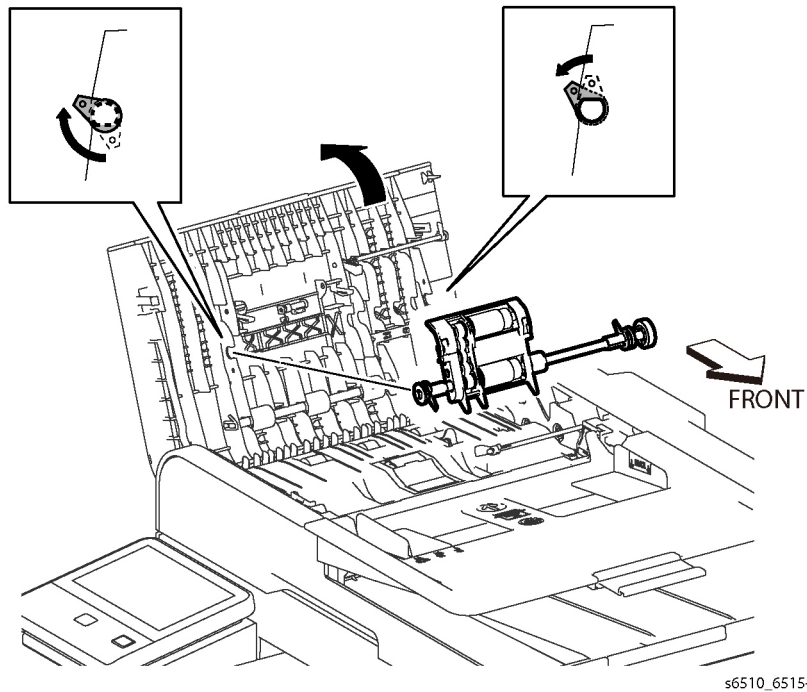
Figure 1 Remove the DADF Feed Roller

1. Refer to Figure 1 to open the DADF Upper Feeder Assembly.

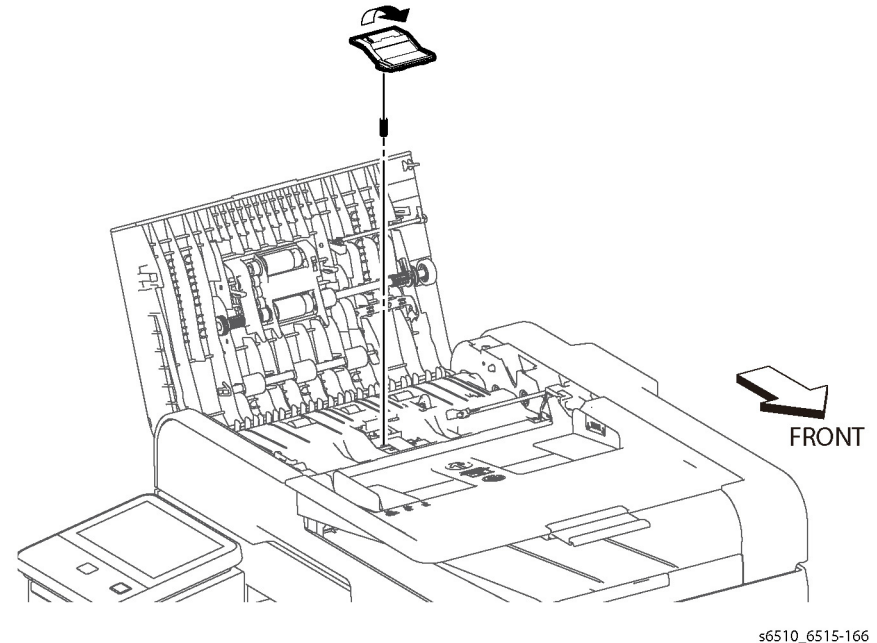
Figure 2 Remove the DADF Separator Cover and Spring

2. Refer to Figure 1 to rotate the two hooks, one on each side of the DADF Feed Roller, and release the bosses.
3. Remove the DADF Feed Roller.
4. Refer to Figure 2 to remove the Separator Cover Assembly in the direction of the arrow.
5. Remove the DADF Separator Spring.

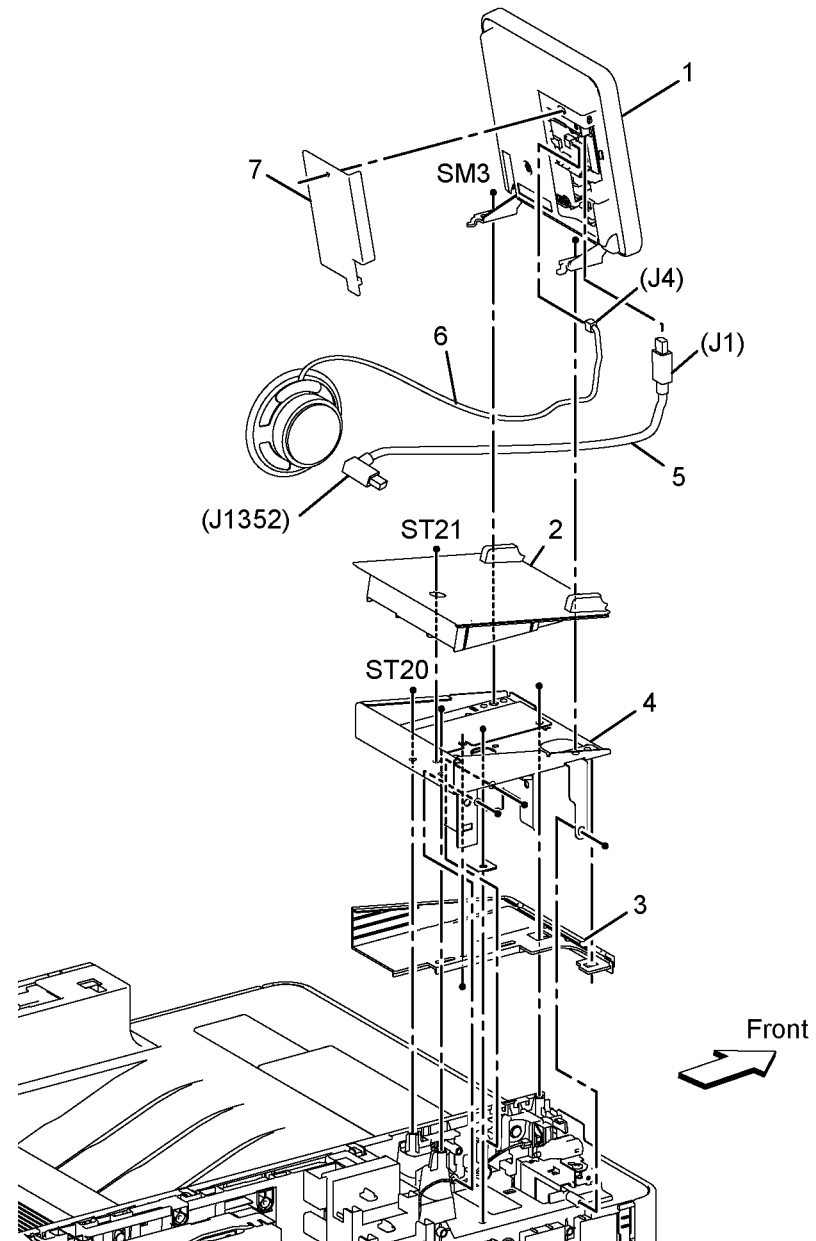
Item	Part	Description
1	848K95745	UI Console Assy MFP
2	-	UI Inner Cover
3	-	UI Frame Cover
4	-	UI Frame Assy
5	952K20900	UI Harness (J1352-J1)
6	-	Speaker Harness
7	822E32001	UI Access Door
99	607K00020	Kit UI Frame Assy (with 2-4)

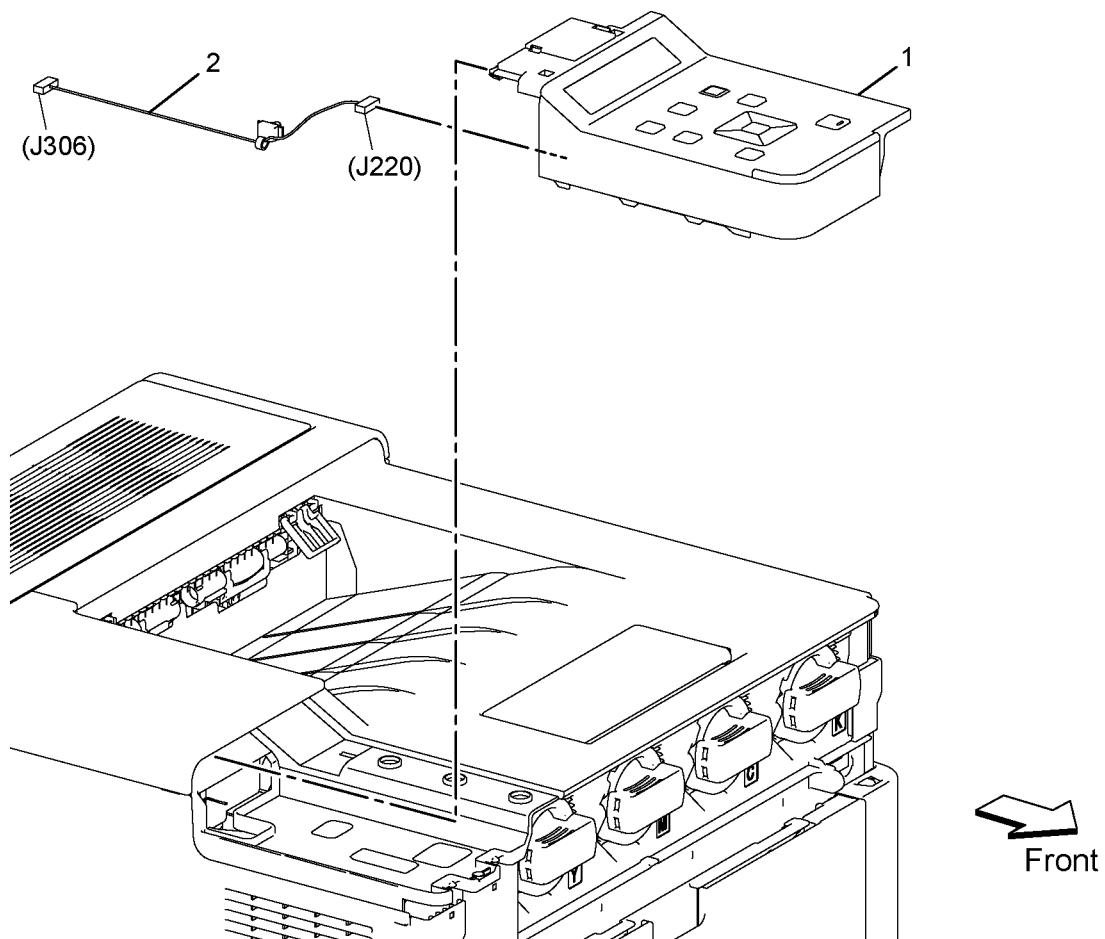
PL 1.2 UI (SFP)

Item	Part	Description
1	848K95775	UI Console Assy SFP
2	952K20952	UI Harness (J306-J220)

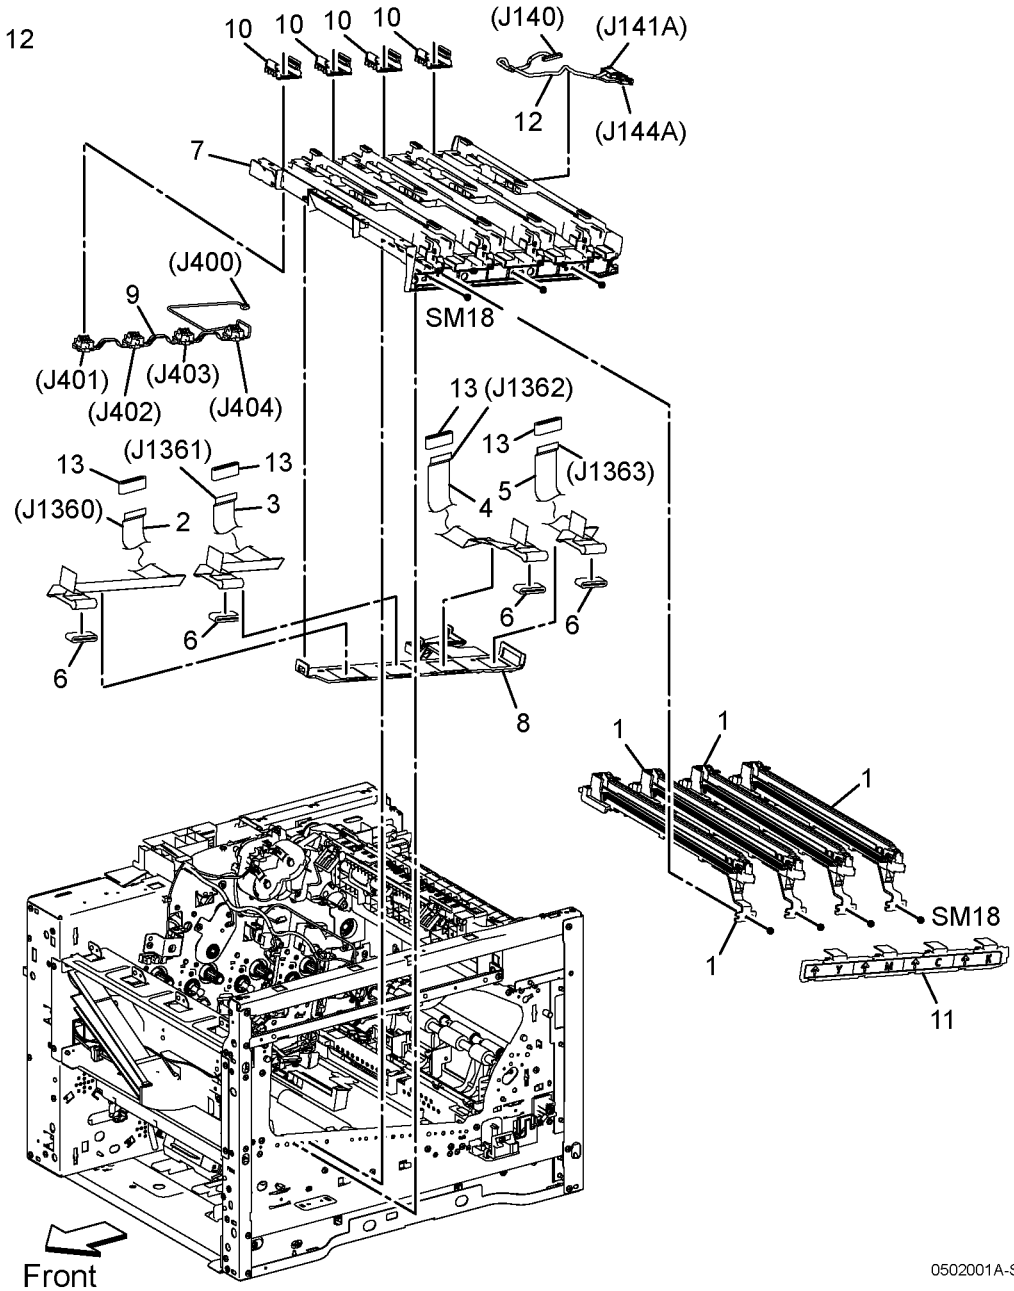
PL 2.1 LPH

Item	Part	Description
1	930K00990	Head Assy LPH Color
2	-	FFC Assy LPH Y (J1360)
3	-	FFC Assy LPH M (J1361)
4	-	FFC Assy LPH C (J1362)
5	-	FFC Assy LPH K (J1363)
6	-	Core Ferrite LPH
7	-	Guide Drum Cartridge
8	-	Cover Core
9	-	Harness Assy Deve/Xero C (J400- J404-J403-J402-J401)
10	-	Holder CRUM Xero
11	604K98080	Cover Assy Guide
12	-	Harness Assy Rad Hum (J140- J141A, J144A)
13	-	Core Ferrite LPH
99	604K97600	Kit Xero CRUM LPH FFC (With 2- 10, 12)

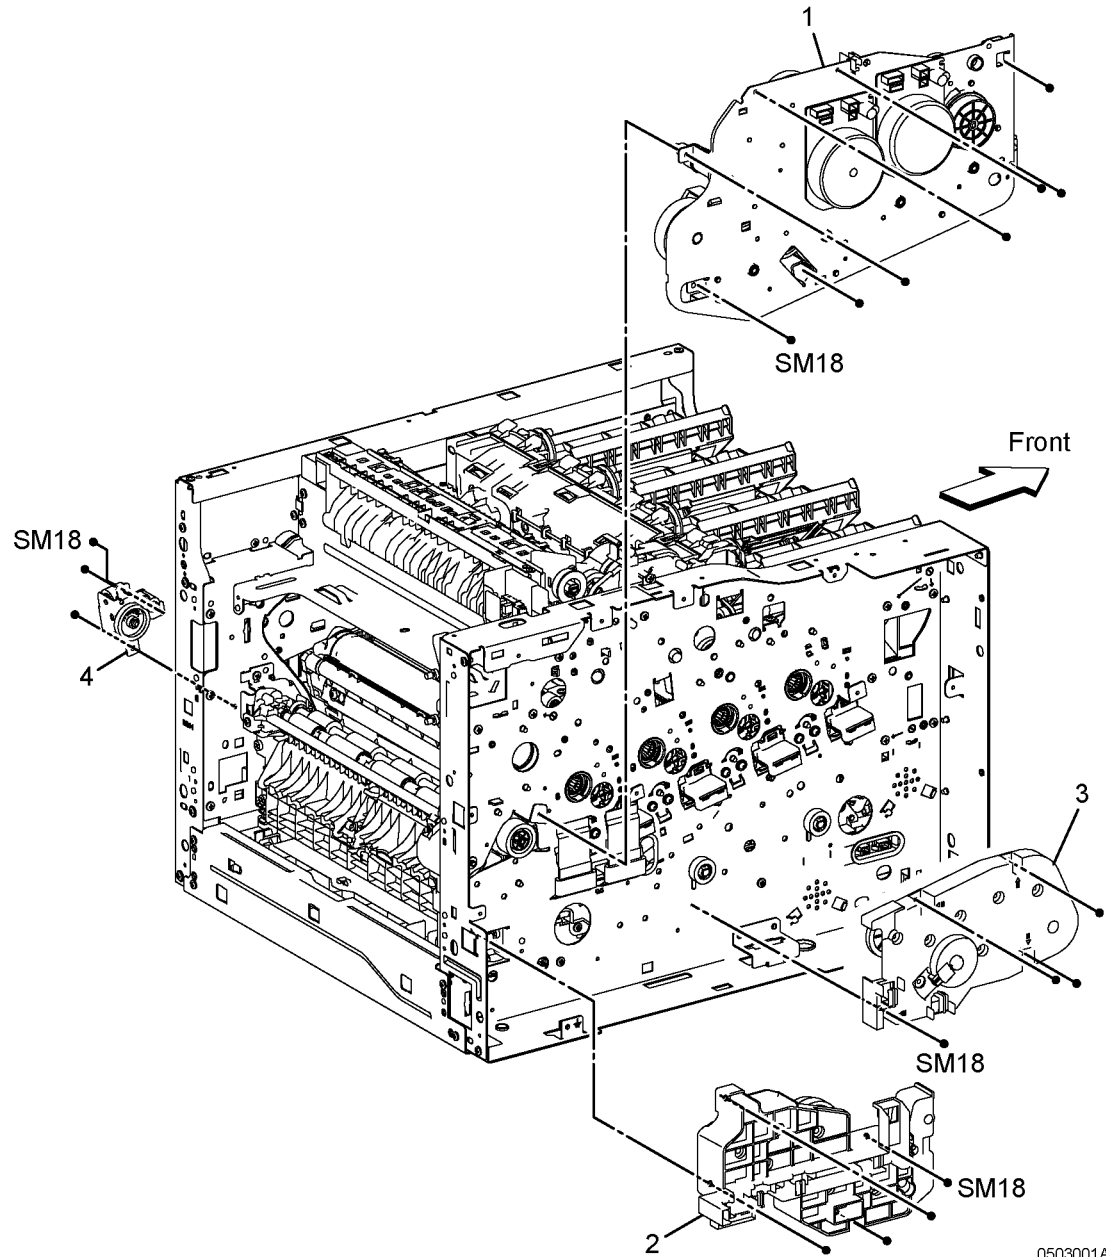
PL 3.1 Drive

Item	Part	Description
1	007K21968	Main Drive Assy (SCC)
2	007K21972	PH Drive Assy
3	007K21981	MSI Drive Assy
4	005K84490	Waste Drive Assy

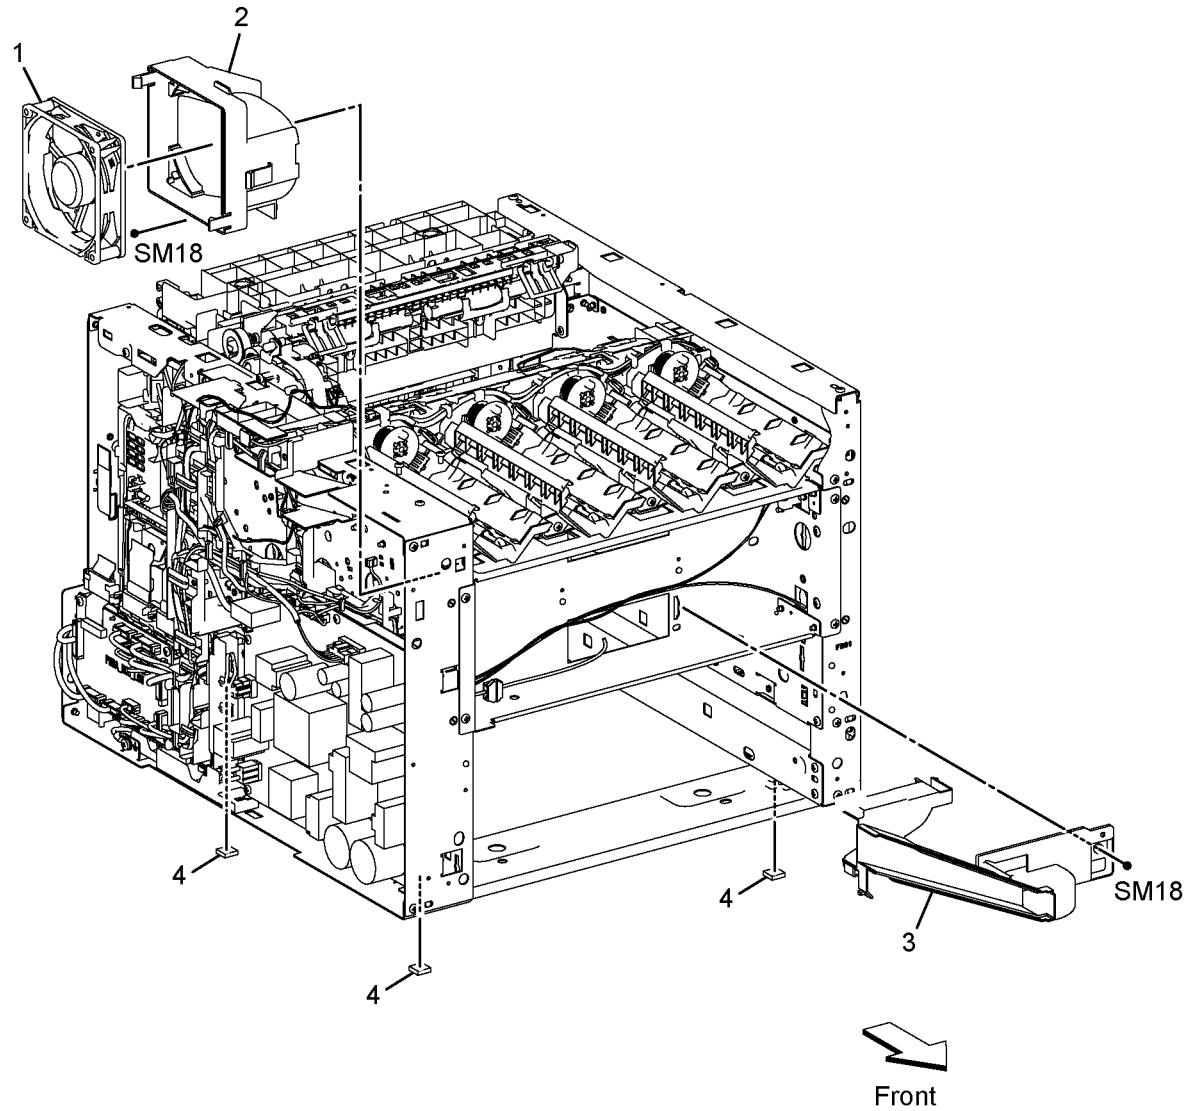
PL 4.1 NOHAD

Item	Part	Description
1	127K74080	Main Fan (SCC)
2	-	Main Duct Fan
3	-	Process Duct
4	017K94350	Foot Assy
99	604K77650	Kit Foot Assy

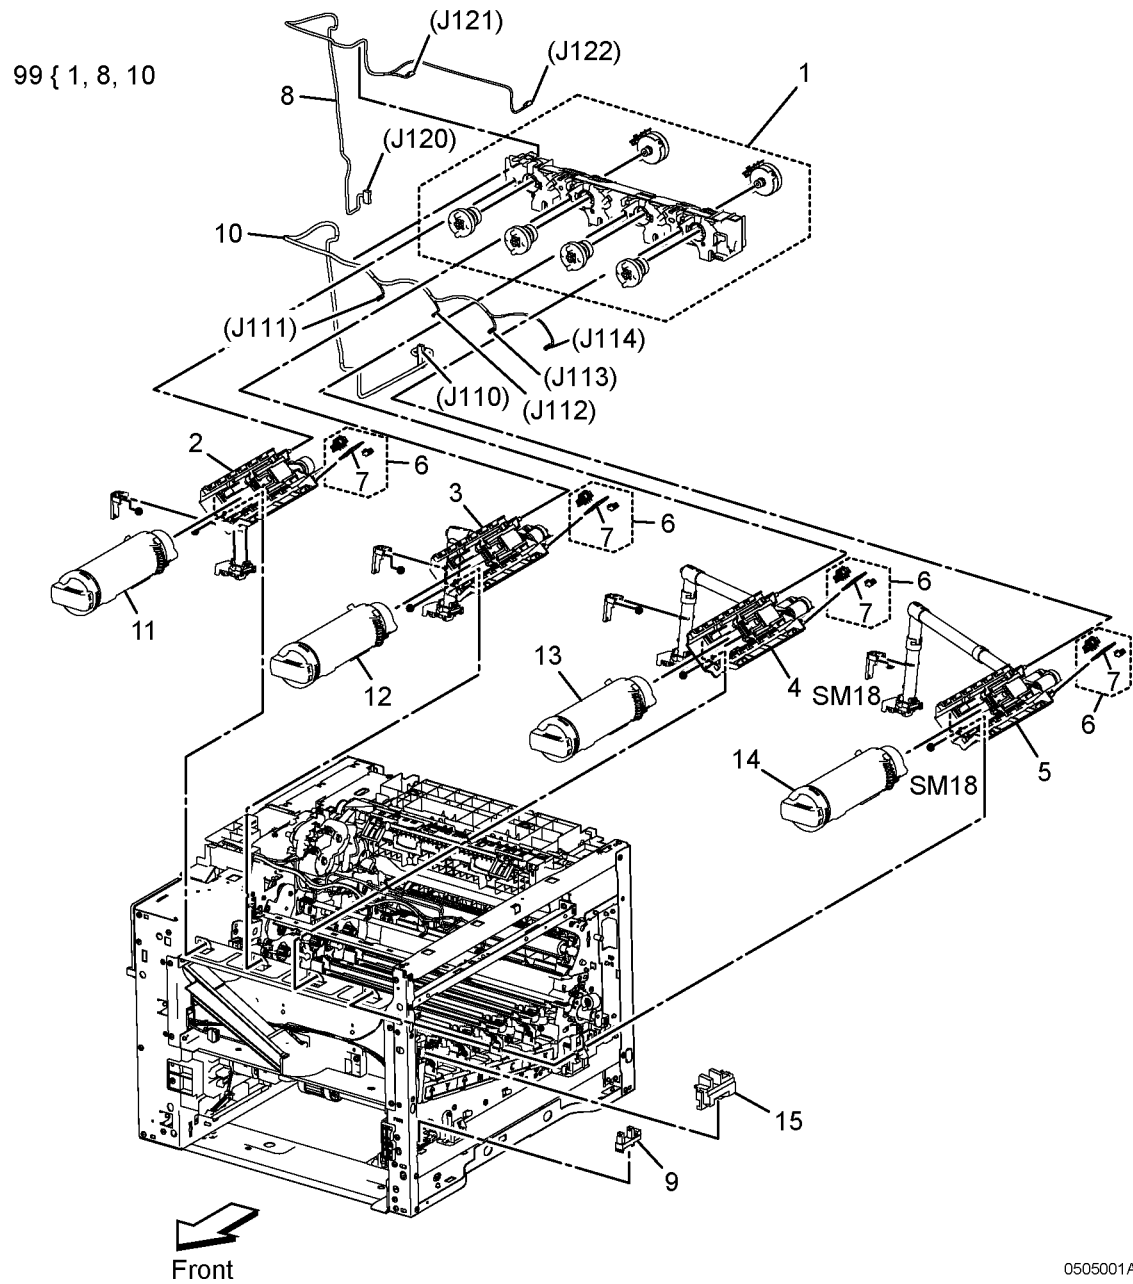
PL 5.1 Dispenser

Item	Part	Description
1	-	Drive Assy Disp
2	094K94240	Disp Assy Y (With 6-7)
3	094K94250	Disp Assy M (With 6-7)
4	094K94260	Disp Assy C (With 6-7)
5	094K94270	Disp Assy K (With 6-7)
6	113K83840	Toner CRUM Connector Assy (With 7)
7	-	Toner CRUM PWBA
8	-	Harness Assy Disp (J120-J121, J122)
9	930W00511	Toner Full Sensor
10	-	Toner CRUM Harness Assy (J110-J111-J112-J113-J114)
11	-	Toner Cartridge Y
12	-	Toner Cartridge M
13	-	Toner Cartridge C
14	-	Toner Cartridge K
15	-	Clear Cover
99	604K97530	Kit Drive Assy Disp (With 1, 8, 10)

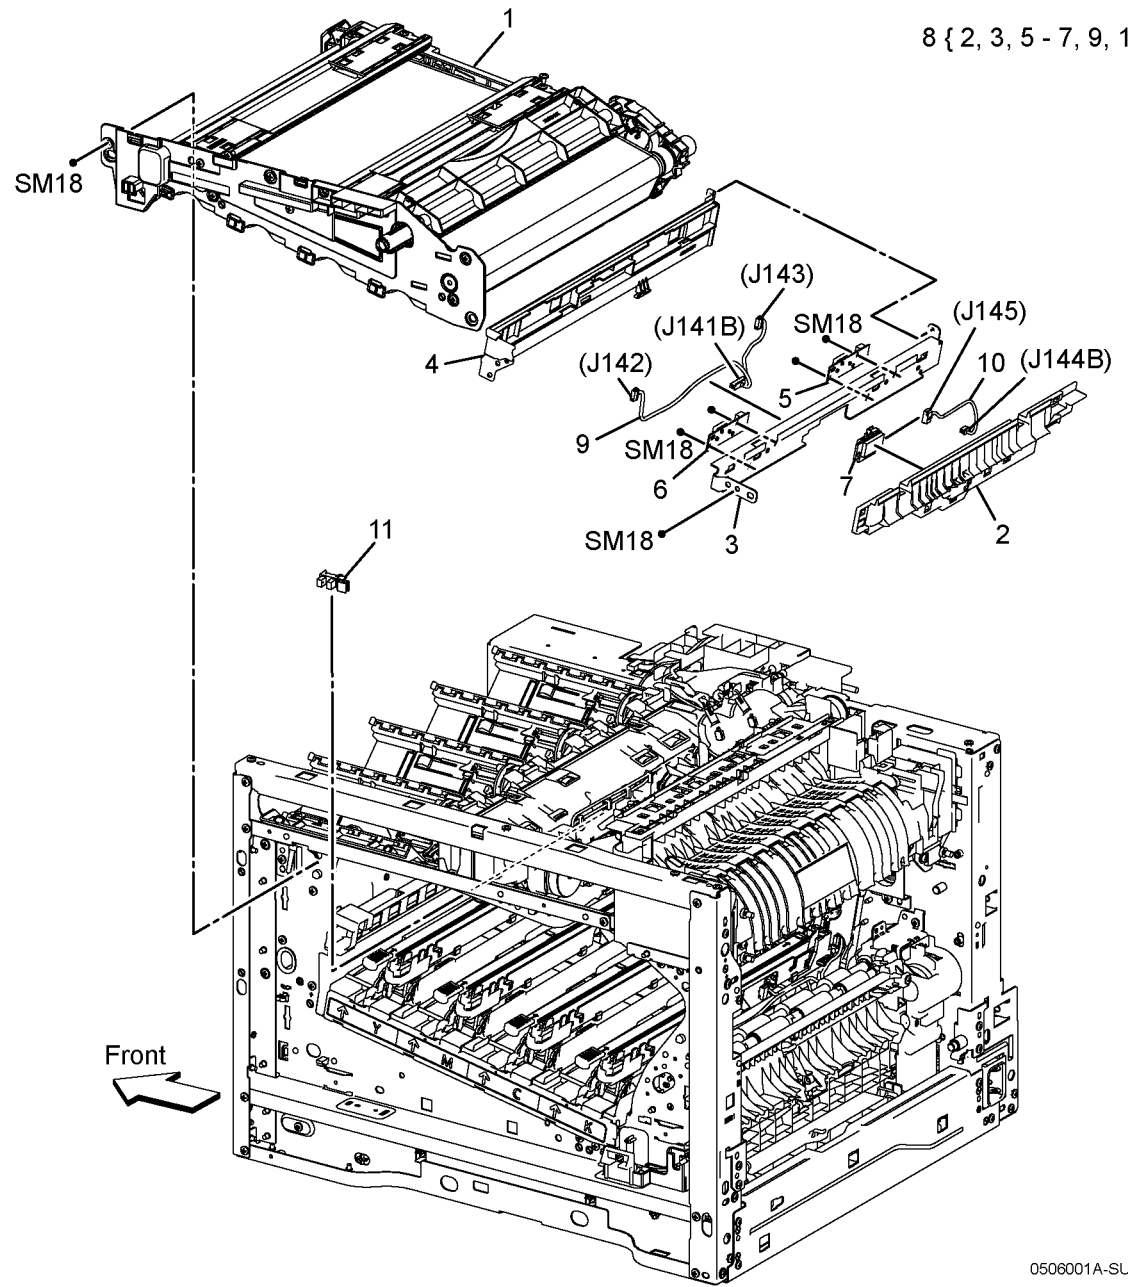
PL 6.1 Transfer

Item	Part	Description
1	607K00930	Transfer Belt Unit
2	-	CTD Upper Chute
3	-	CTD Plate
4	-	Sensor Cover
5	-	Sensor R-RAD A (R-RAD Sensor)
6	-	Sensor R-RAD Low A (R-RAD Low Sensor)
7	-	Sensor Hum And Temp (Humi. and Temp. Sensor)
8	930K00210	CTD Sensor Assy (With 2, 3, 5-7, 9, 10)
9	-	CTD Harness Assy (J141B-J142, J143)
10	-	Humidity and Temperature Sensor Harness Assy (J144B-J145)
11	930W00123	Interlock Photo Sensor (K Mode Sensor)

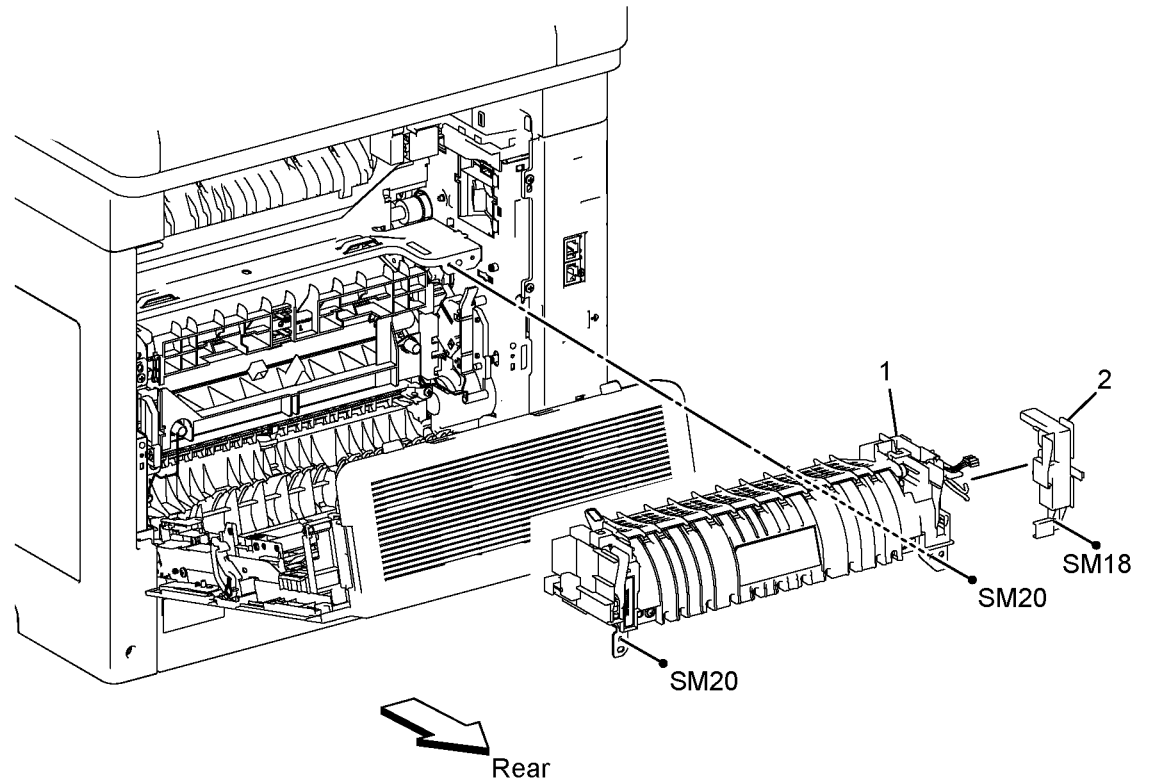
PL 7.1 Fuser

Item	Part	Description
1	126K36430	Fuser Assy 110V (SCC)
—	126K36440	Fuser Assy 220V (SCC)
2	822E20922	Fuser Harness Cover

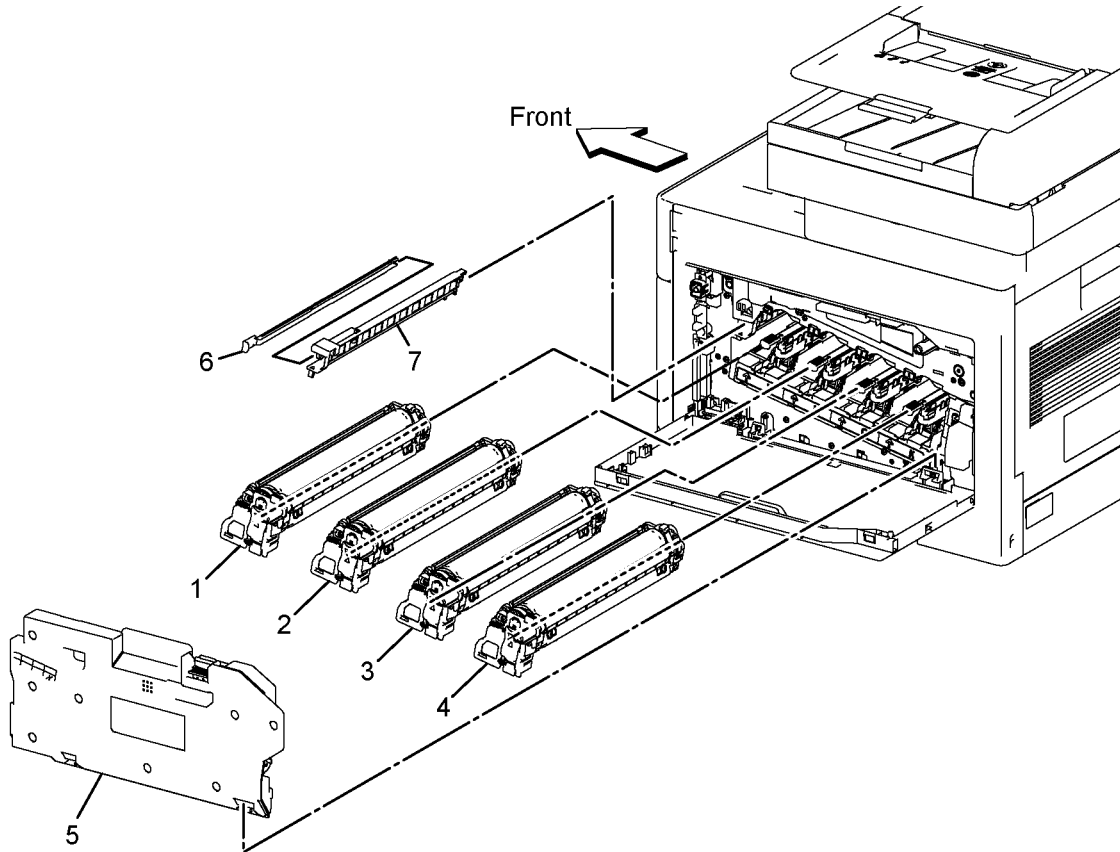
PL 8.1 Xerographic

Item	Part	Description
1	-	Drum Cartridge CRU Assy Y
2	-	Drum Cartridge CRU Assy M
3	-	Drum Cartridge CRU Assy C
4	-	Drum Cartridge CRU Assy K
5	-	Waste Cartridge Assy
6	042K94970	LPH Cleaner Assy
7	-	Clean Cover
