Phaser® 6510, WorkCentre® 6515 Service Manual

Xerox Phaser 6510 Color Printer/WorkCentre 6515 Color Multifunction Printer

Phaser 6510 Color Printer/WorkCentre 6515 Color Multifunction Printer Service Manual

705P01382

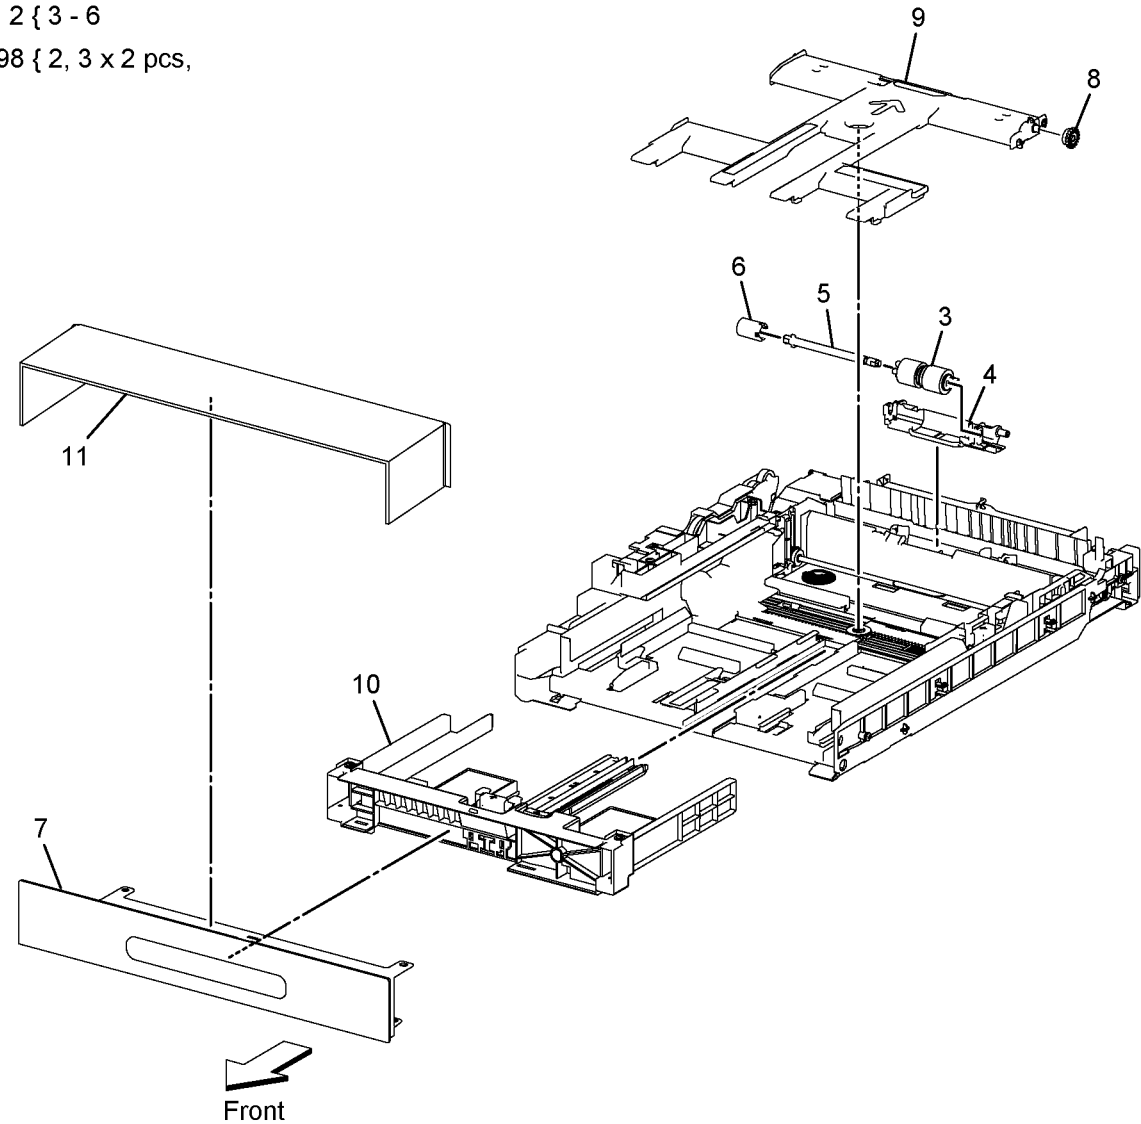
PL 9.1 Tray

Item	Part	Description	
1	607K00960	Cassette Assy 250 IOT (SCC) (With 2-10)	1 { 2 - 10
2	019K17070	Holder Assy Separator CST (With 3-6)	2 { 3 - 6
3	-	Cassette Feed Roll Assy (P/O PL 10.2 Item 7)	98 { 2, 3 x 2 pcs,
4	-	Separator Holder	
5	-	Cassette Separator Shaft	
6	-	Friction Clutch Assy	
7	-	Handle CST 250	
8	-	Gear Assy	
9	-	Bottom Plate Assy	
10	-	Housing Assy End 250	
11	948K11160	Dust Cover 250 (with Label)	
98	607K00051	Kit Feed And Separator Roll (With 2, 3x2 Pcs)

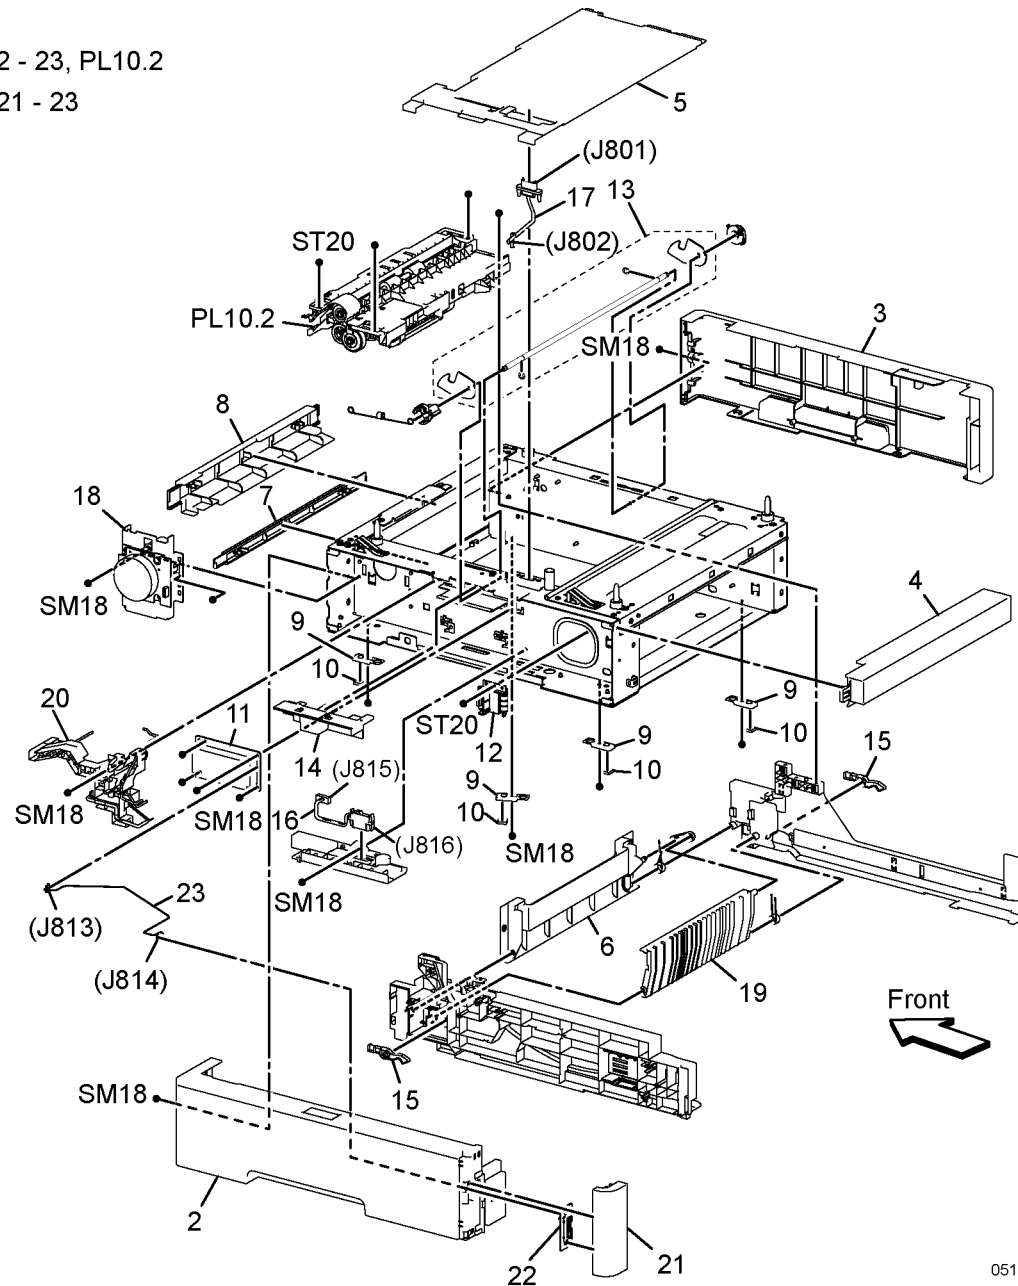
PL 10.1 Option Feeder (1/3)

Item	Part	Description	
1	607K01910	Kit Feeder Assy OPF 550 (With 2 - 23, PL 10.2)	1 { 2 - 23, PL10.2
2	-	Cover Side Left OPF 550	98 { 21 - 23
3	-	Cover Side Right OPF 550	
4	-	Cover Lip Top OPF 550	
5	-	Cover Top OPF 550	
6	-	Cover Rear OPF 550	
7	-	Cover Rear Under OPF 550	
8	-	Cover Rear Top OPF 550	
9	-	Foot Base OPF 550	
10	017K94350	Foot OPF 550	
11	-	PWB Assy OPF 550	
12	110K16610	Switch Assy Size OPF 550	
13	-	Lock Assy OPF 550	
14	-	Gear Rack Lock OPF 550	
15	-	Latch Tray OPF 550	
16	-	Harness Assy FDR Drawer (J815-J816)	
17	-	Harness Assy OPF 2C (J802-J801)	
18	-	Motor Assy Drive OPF 550	
19	-	Chute Rear OPF 550	
20	-	Guide Harness OPF 550	
21	-	Front Left Cover OPF	
22	-	Tray LED Assy (ACO/MEXICO/FX)	
23	-	LED Harness Assy (J813-J814)	
98	607K00450	Kit OPT FDR LED (With 21 - 23)

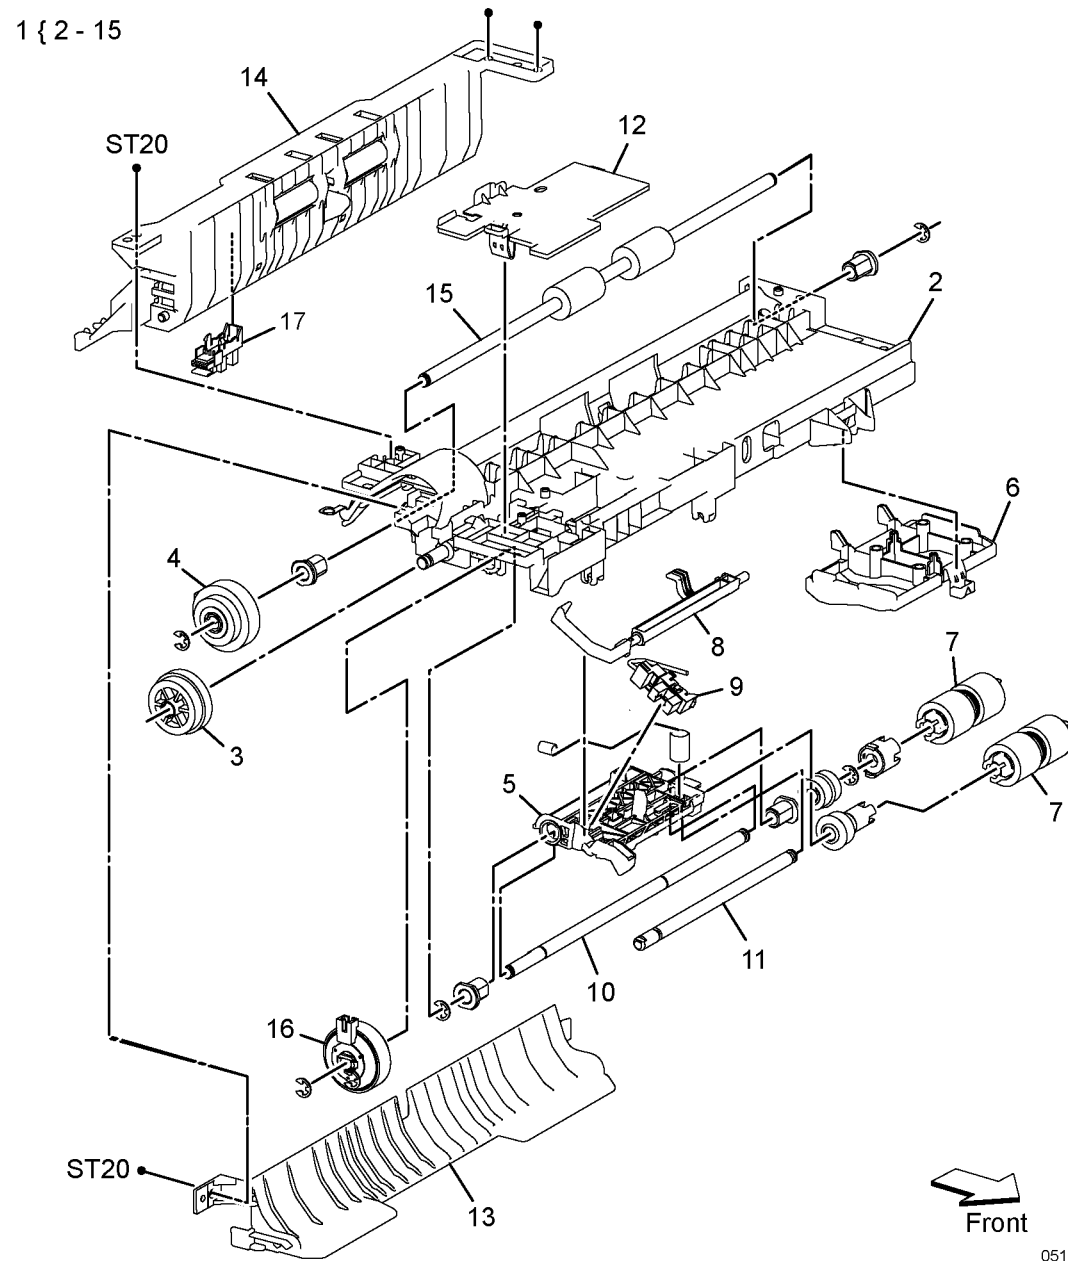
PL 10.2 Option Feeder (2/3)

Item	Part	Description
1	—	Option 550 Feeder Assy (With 2-15)
2	—	Feeder Top Frame
3	—	Gear P24-P27
4	—	Option 550 Feeder Clutch Assy
5	—	Nudger Support
6	—	Upper Feed Chute
7	859K00100	Feed Roll Assy
8	120E35551	No Paper Actuator
9	—	Photo Sensor (Optional Feeder No Paper Sensor)
10	—	Option 550 Feed Shaft
11	—	Option 550 Feeder Nudger Shaft
12	—	Option 550 Feeder Harness Cover
13	—	Feeder Chute
14	—	Option 550 Feeder Tray Pinch Roll Assy
15	—	Option 550 Feeder Tray Roll Assy
16	—	Option 550 Feeder Clutch Assy (SCC) (Optional Feed Clutch)
17	—	Photo Sensor (Optional Path Paper Sensor)

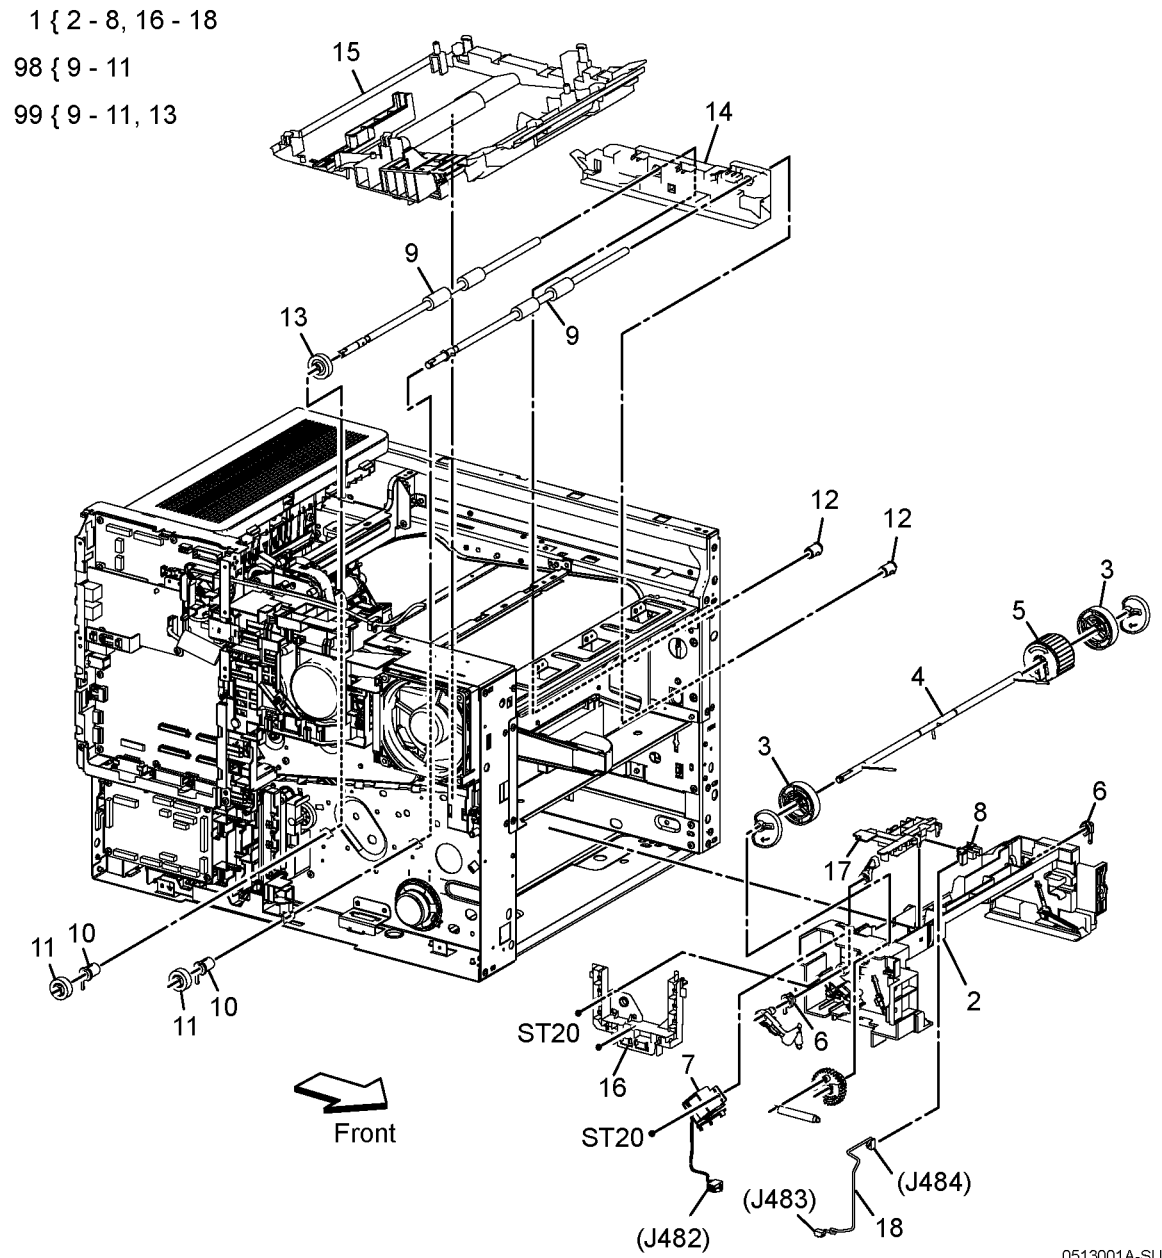
PL 13.1 MSI (1/2)

Item	Part	Description
1	801K64710	MSI Frame Assy (With 2-8, 16-18)
2	-	MSI Frame
3	-	MSI Roll Core
4	-	MSI Feed Shaft Assy
5	059K89701	MSI Feed Roll
6	-	MSI Duplex Bearing
7	-	MSI Feed Solenoid (J482)
8	930W00123	Internal Photo Sensor (MSI No Paper Sensor)
9	-	TA1 Roll Assy
10	-	TA L Bearing
11	-	Turn Gear
12	-	TA3 AD Bearing
13	-	TA2 Gear
14	-	Right MSI Guide
15	-	MSI Upper Chute
16	-	MSI Guide Harness
17	-	MSI No Paper Bracket
18	-	MSI No Paper Harness Assy (J483-J484)
99	604K97990	Kit MSI Roll Assy TA2 (With 9-11, 13)

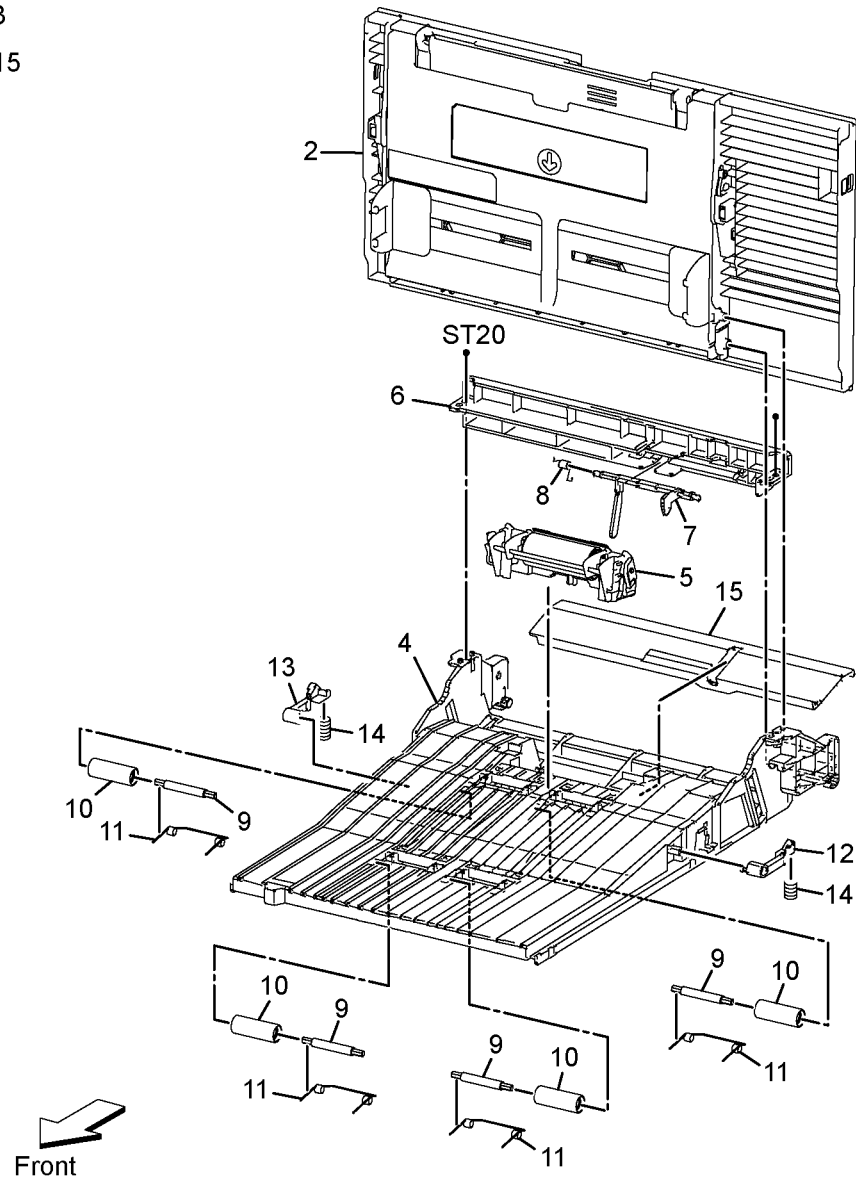
PL 13.2 MSI (2/2)

Item	Part	Description	
1	050K73481	MSI Main Tray Assy (With 2-3)	1 { 2 - 3
2	-	MSI Cover Assy	
3	-	MSI Chute Assy (With 4-15)	3 { 4 - 15
4	-	Chute MSI	
5	607K04060	MSI Separator Holder Assy	
6	-	MSI Front Bar	
7	-	MSI No Paper Actuator	
8	-	Spring No Paper MSI	
9	-	Pinch Shaft TA	
10	-	MSI Pinch Roll	
11	-	MSI Pinch Spring	
12	-	MSI Left Latch	
13	-	MSI Right Latch	
14	-	MSI Latch Spring	
15	-	MSI Bottom Plate Assy

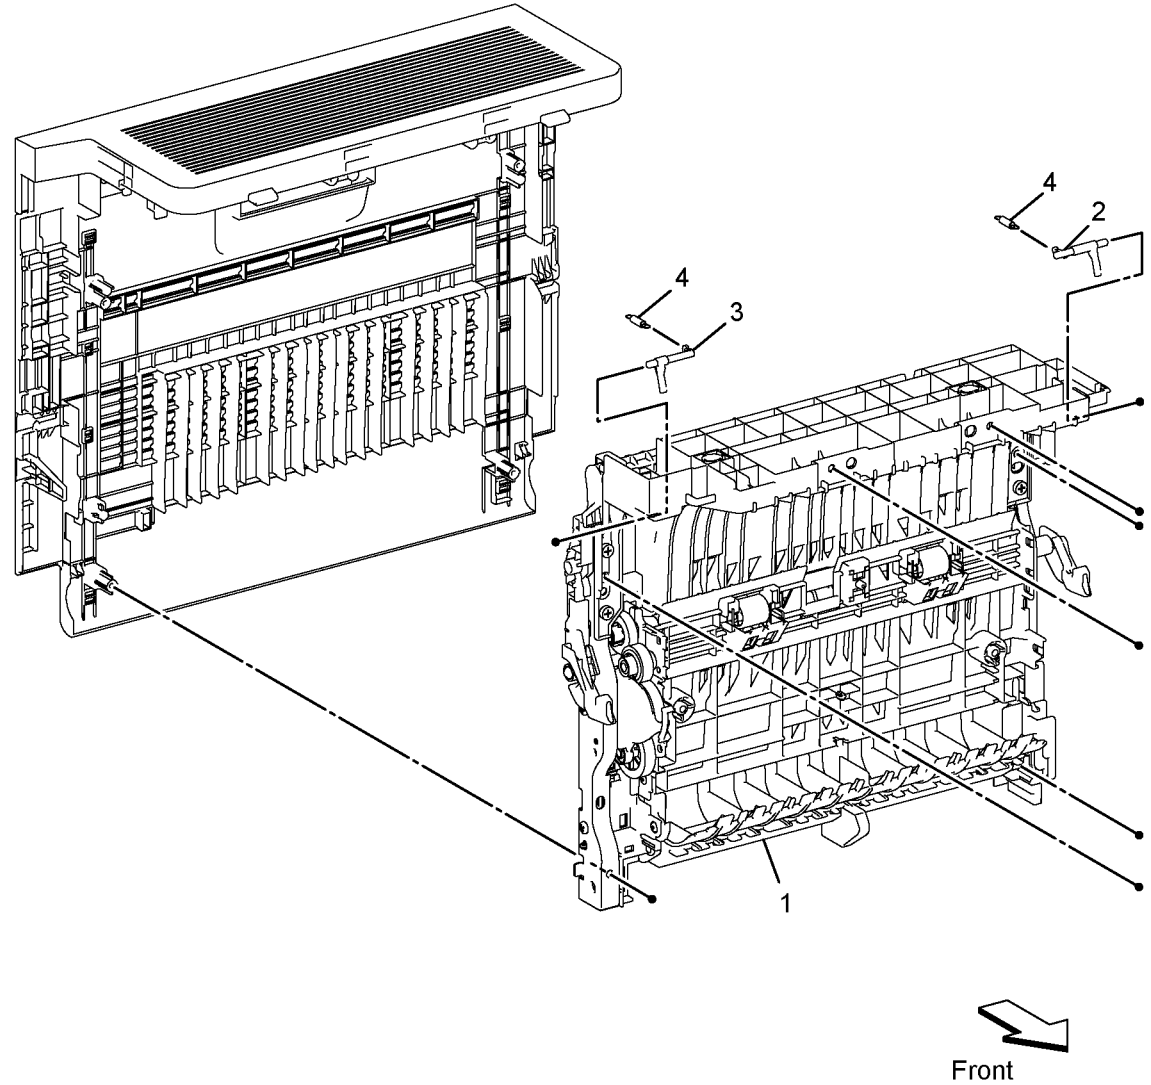
PL 14.1 Duplex

Item	Part	Description
1	-	Duplex Assy
2	-	Release Arm Fuser AD
3	-	Release Arm Fuser D
4	-	Fuser Release Spring

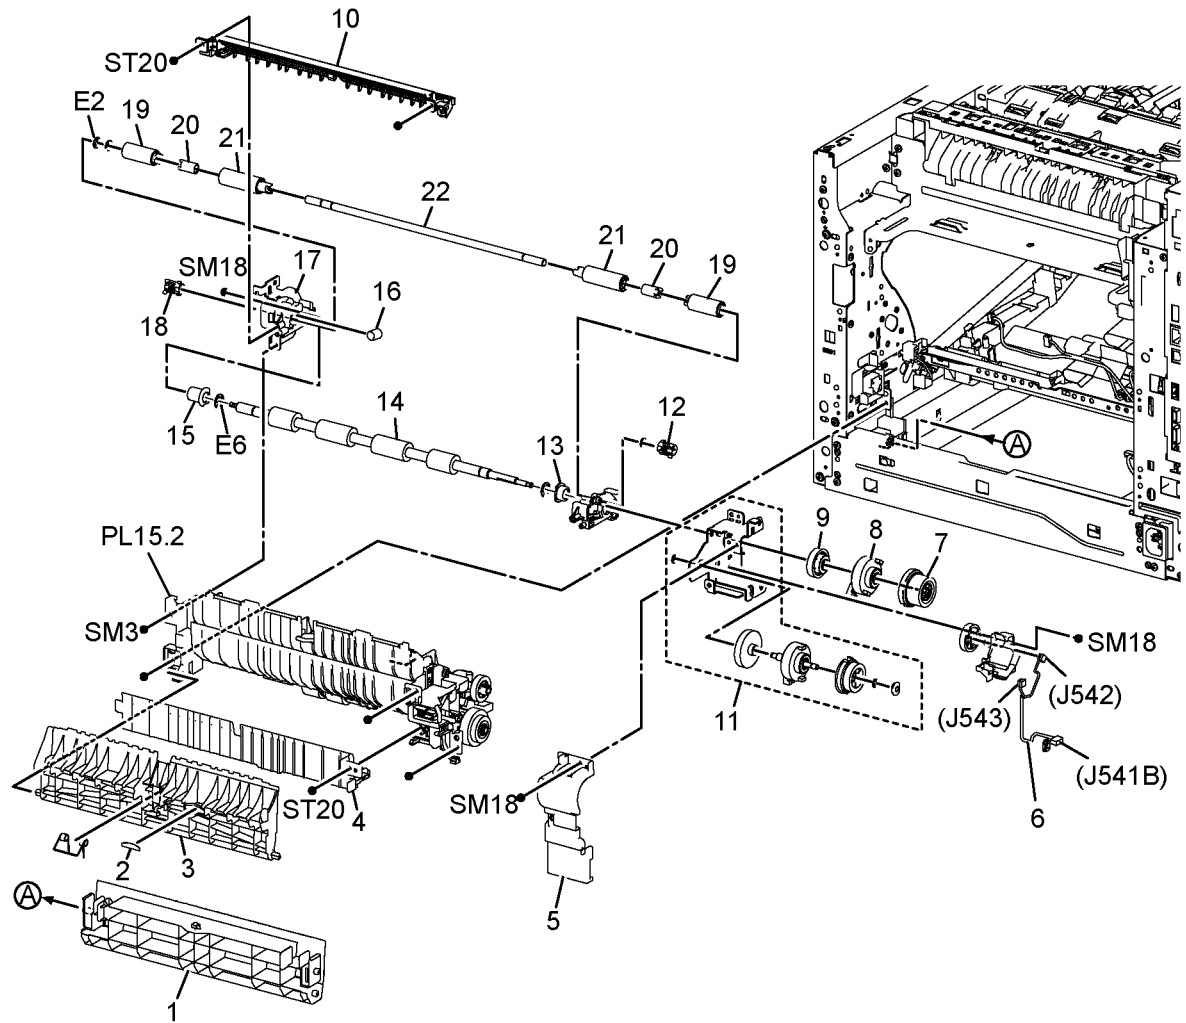
PL 15.1 Registration (1/2)

Item	Part	Description
1	054E56460	Option 250 Chute
2	-	Chute Jam Label
3	-	Lower Duplex Chute
4	-	Feeder Chute
5	-	Duplex Gear Cover
6	-	Harness Assy Clutch Regi/Dup -C (J541B-J542, J543)
7	-	Gear CLT Regi
8	-	Registration Clutch Assy (SCC)
9	-	One Way Gear Assy
10	-	Upper Duplex Chute
11	-	Registration Bracket Assy D (SCC)
12	-	Registration Pinch Bearing AD
13	-	Registration Bearing AD
14	-	Registration Roll Assy
15	-	Registration Bearing D
16	-	Registration Spring
17	-	Registration Bracket Assy AD
18	-	Registration Pinch Bearing D
19	-	Registration Pinch Out Roll
20	-	Registration Pinch Spacer
21	-	Registration Pinch In Roll
22	-	Registration Pinch Shaft
99	604K98121	Kit Roll Assy Dup Regi (With 6-9, 11-22, 2 E-rings)

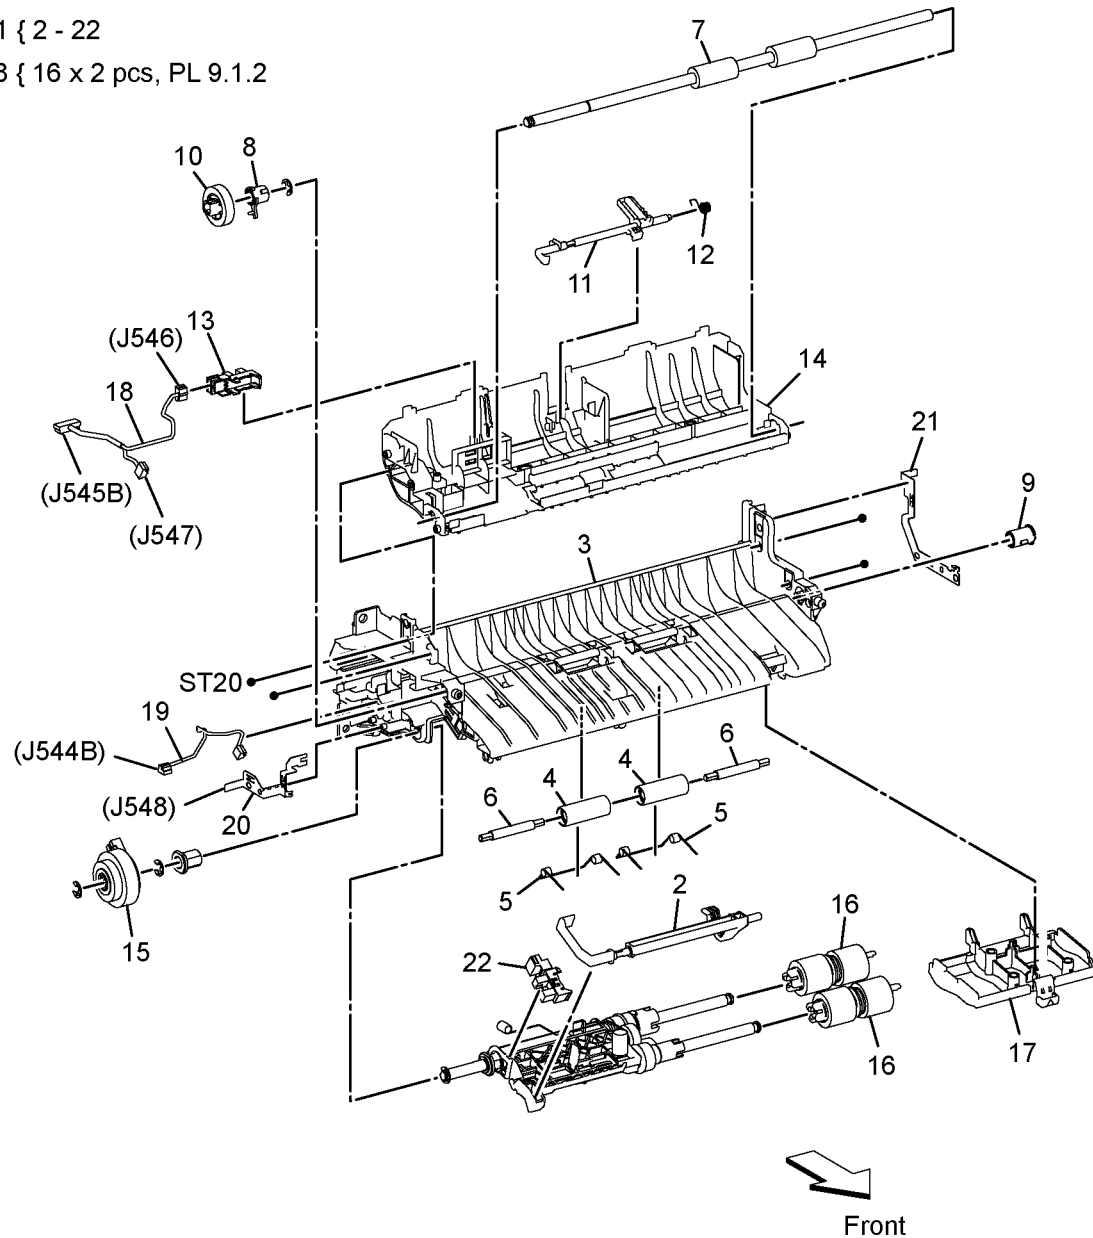
PL 15.2 Registration (2/2)

Item	Part	Description
1	054K56930	Registration Feeder Chute Assy (SCC) (With 2-22)
2	120E35551	No Paper Actuator
3	-	Registration Chute
4	-	Pinch Roll TA
5	-	Pinch Spring TA
6	-	Pinch Shaft TA
7	-	Roll Assy TA3
8	-	Bearing TA3 D
9	-	Bearing TA3 AD
10	-	Gear TA3
11	120E35530	Registration Actuator
12	-	Registration Spring Actuator
13	930W00123	Photo Sensor Int (Regi Sensor)
14	-	Registration Upper Chute
15	-	Clutch Assy PH
16	859K00100	Feed Roll Assy
17	054E60150	Upper Feed Chute
18	-	Harness Assy SNR Regi/NO (J545B-J546, J547)
19	-	Harness Assy Clutch Feed (J544B-J548)
20	-	Feed Plate Earth
21	-	Earth Plate TA3
22	-	Photo Sensor Int (No Paper Sensor)
98	607K00050	Kit Feed and Separator Roll (with 16 x 2 pcs, PL 9.1.2)

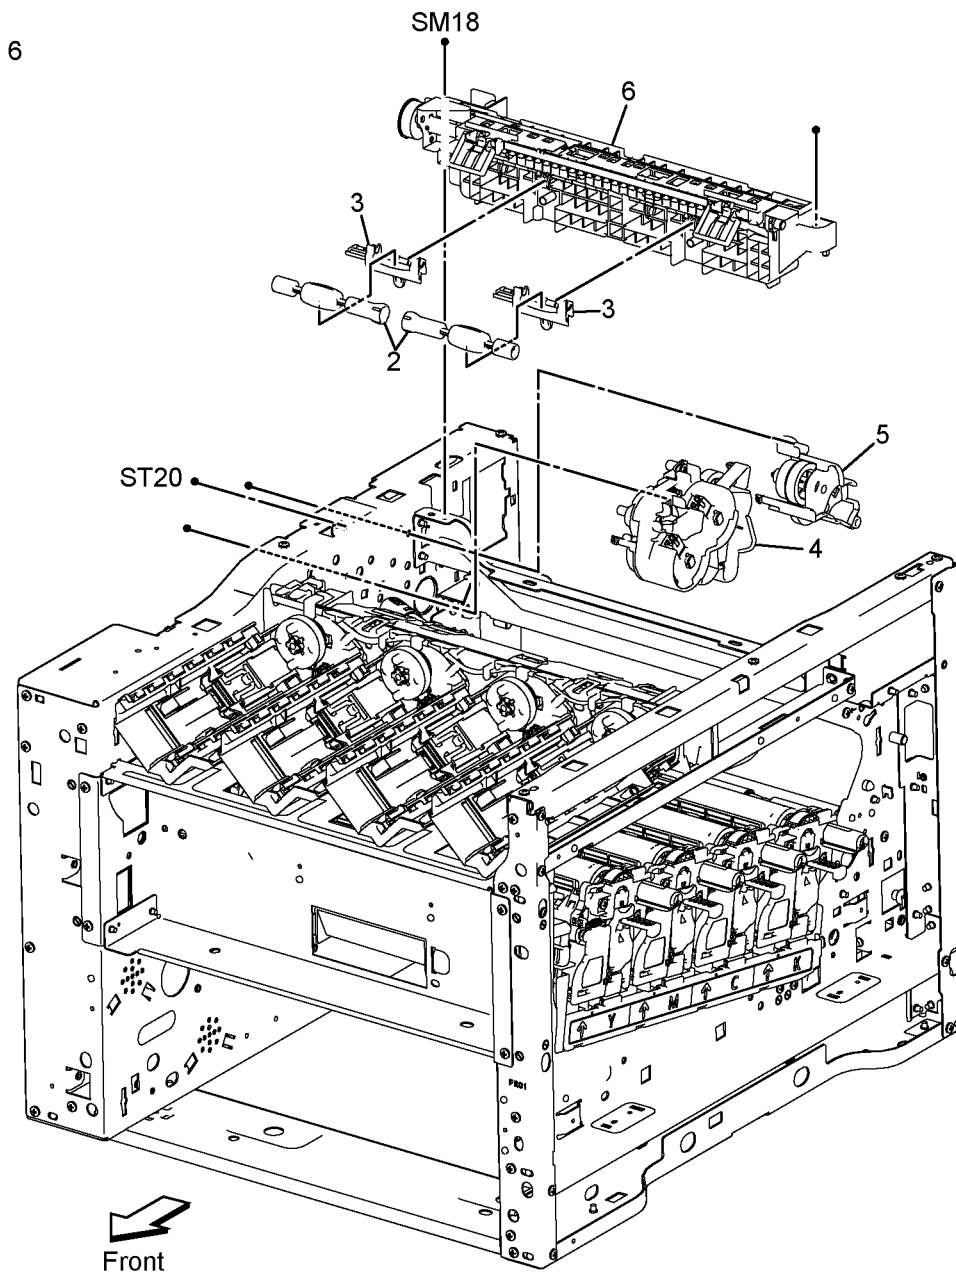
PL 17.1 Exit

Item	Part	Description	
1	054K56411	Exit Chute Assy (With 2-3)	1 { 2, 3, 6
2	-	Pinch Roll	
3	-	Pinch Cover	
4	007K22090	Exit Main Drive Assy (SCC)	
5	007K21391	Idle Exit Gear Assy	
6	-	Chute Exit

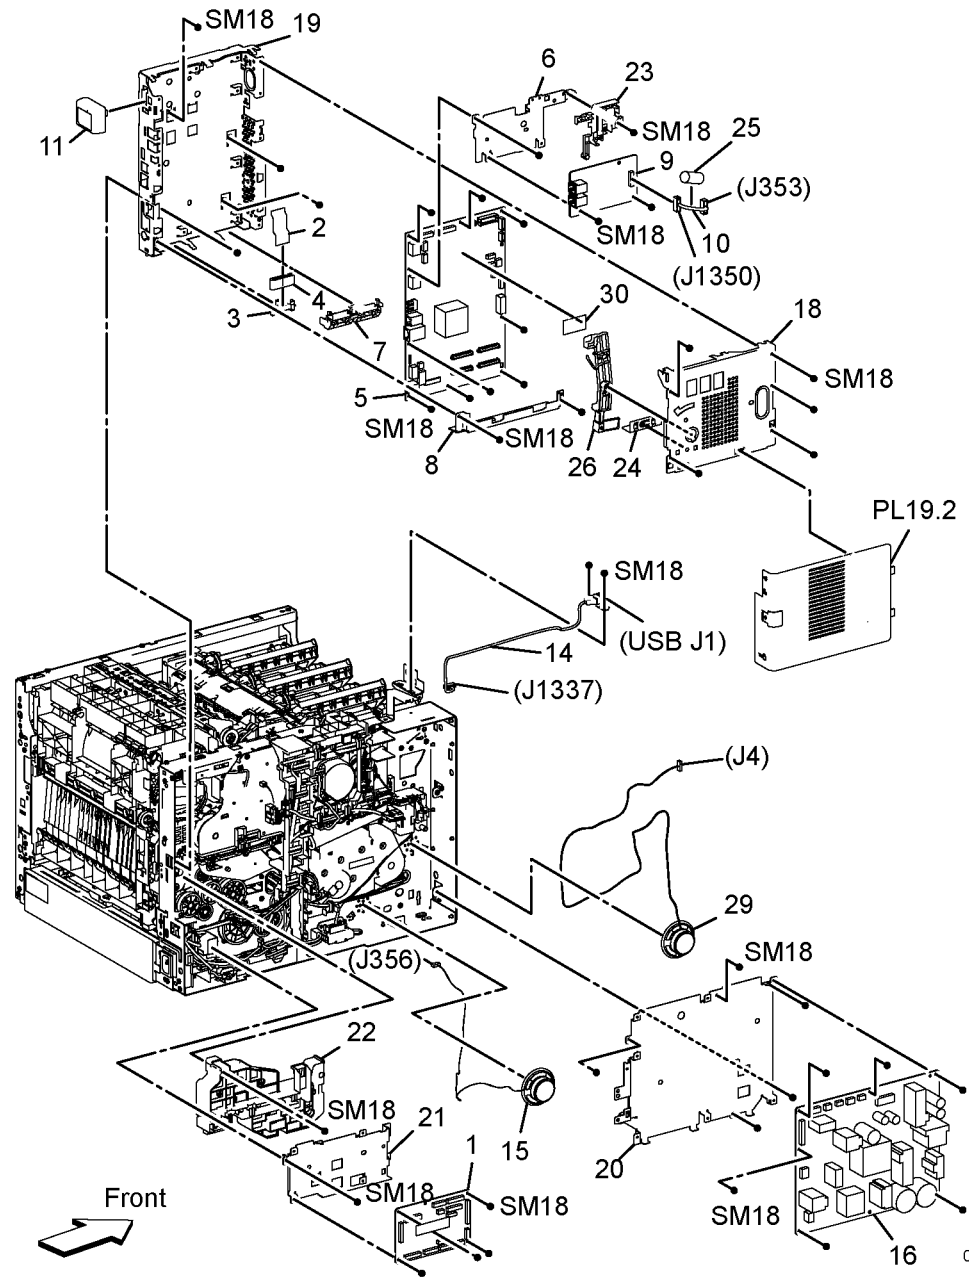
PL 18.1 Electrical MFP (1/4)

Item	Part	Description
1	960K87210	MCU PWBA (SCC)
2	952K22010	ESS MCU FFC Cable
3	-	FFC Color MCU Guide
4	-	Core MCU
5	607K00103	ESS PWBA (SCC) (ISC)
6	-	Fax Plate Assy
7	-	FFC Color LPH Guide
8	-	ESS Low Plate
9	960K80761	PWBA Fax (SCC)
10	-	Fax Harness Assy (SCC)
11	-	Wireless Module
12	-	
13	-	
14	952K33741	Front USB Harness Assy (J1337-USB J1)
15	-	A4 Fax Speaker Assy (J356) (ACO)
16	105K31081	LVPS PWBA 110V (SCC)
-	105K31091	LVPS PWBA 220V (SCC)
17	-	
18	-	ESS Top Plate
19	-	ESS Box MFP
20	-	LVPS Low Plate
21	-	MCU Plate
22	-	Drive PH Housing
23	-	ESS Harness Guide
24	-	Fax Cover
25	-	Core
26	-	WiFi Link
27	-	
28	-	
29	-	Main Speaker (J4)
30	-	EMMC Board

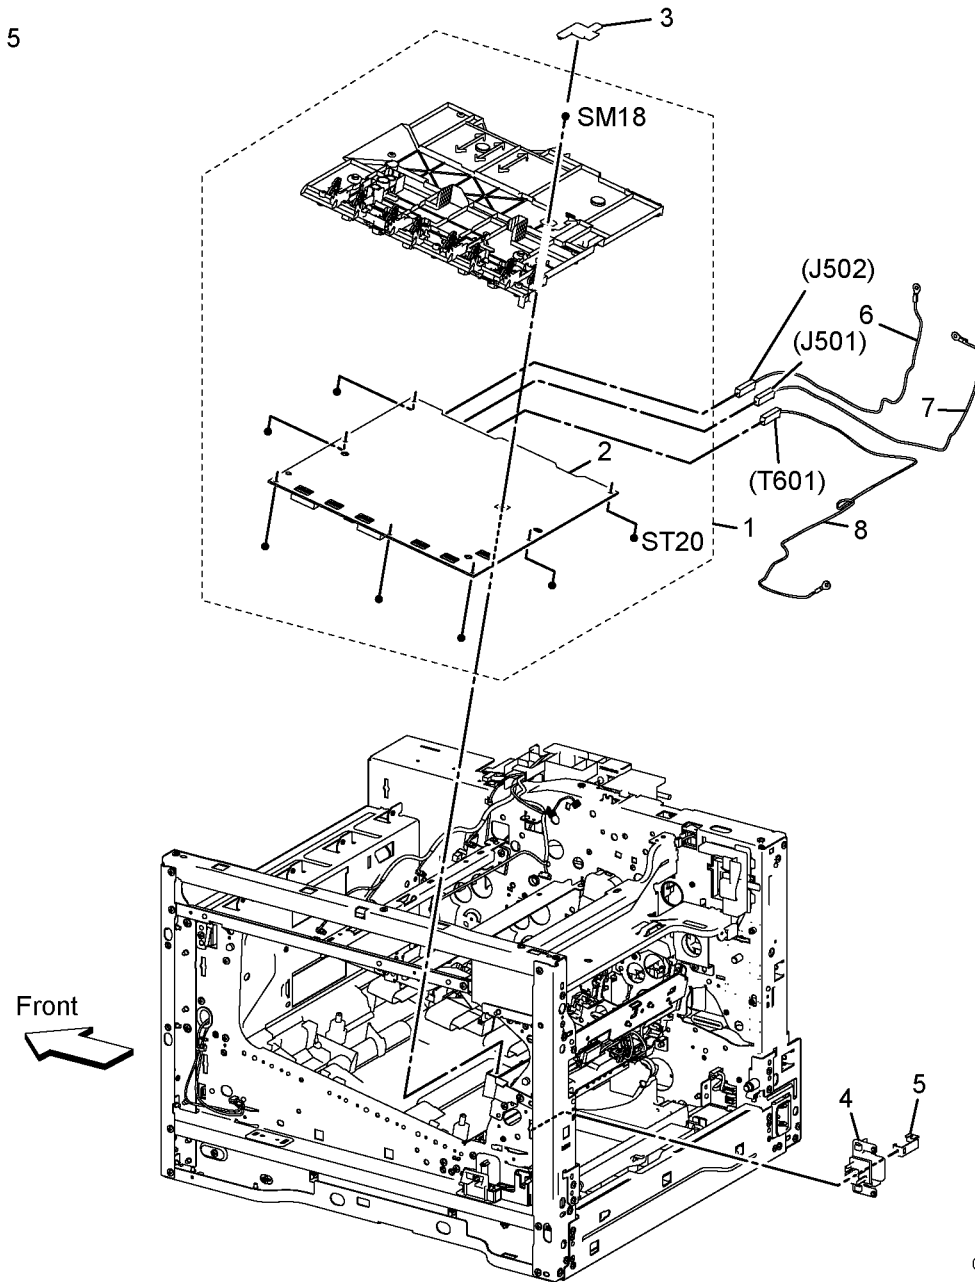
PL 18.2 Electrical MFP (2/4)

Item	Part	Description
1	032K10622	HVPS Guide Assy (With 2)
2	—	HVPS PWBA (SCC) (P/O PL 18.2 Item 1)
3	822E21972	HVPS Toner Cover
4	—	Bias Transfer Roll 2nd Housing
5	—	Bias Transfer Roll 2nd Bias Plate
6	—	1st K Supply Harness Assy (J501)
7	—	1st YMC Supply Harness Assy (J502)
8	—	Trans Supply Harness Assy (T601)
99	604K97510	Kit 2nd Bias Transfer Roll Housing (With 4-5)

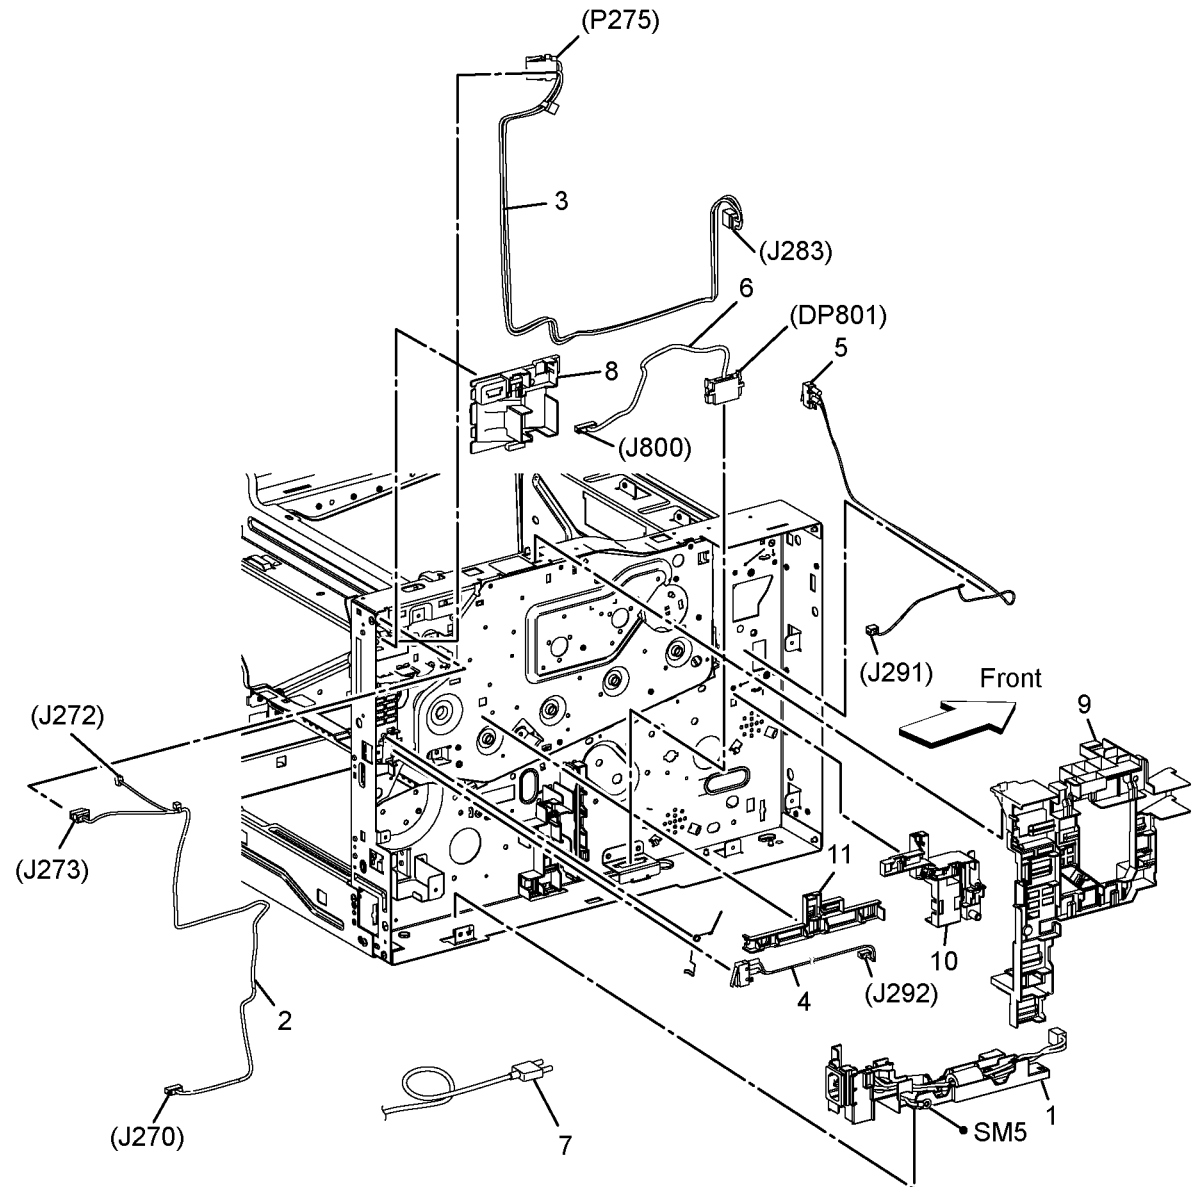
PL 18.3 Electrical MFP (3/4)

Item	Part	Description
1	604K97501	AC Inlet Harness Assy
2	—	Fuser Harness DC (J270-J272, J273)
3A	—	Fuser Harness (AC) 110VAC
3B	—	Fuser Harness (AC) 220VAC
4	952K21870	Rear Interlock Harness Assy (SW-J292)
5	952K21860	Side Interlock Harness Assy (SW-J291)
6	952K21990	OPF Harness Assy (J800-DP801A)
7	—	Power Cord (SCC)
8	—	Fuser Harness Guide
9	—	DC Harness Guide
10	—	Duct Harness Guide
11	—	Interlock Harness Guide

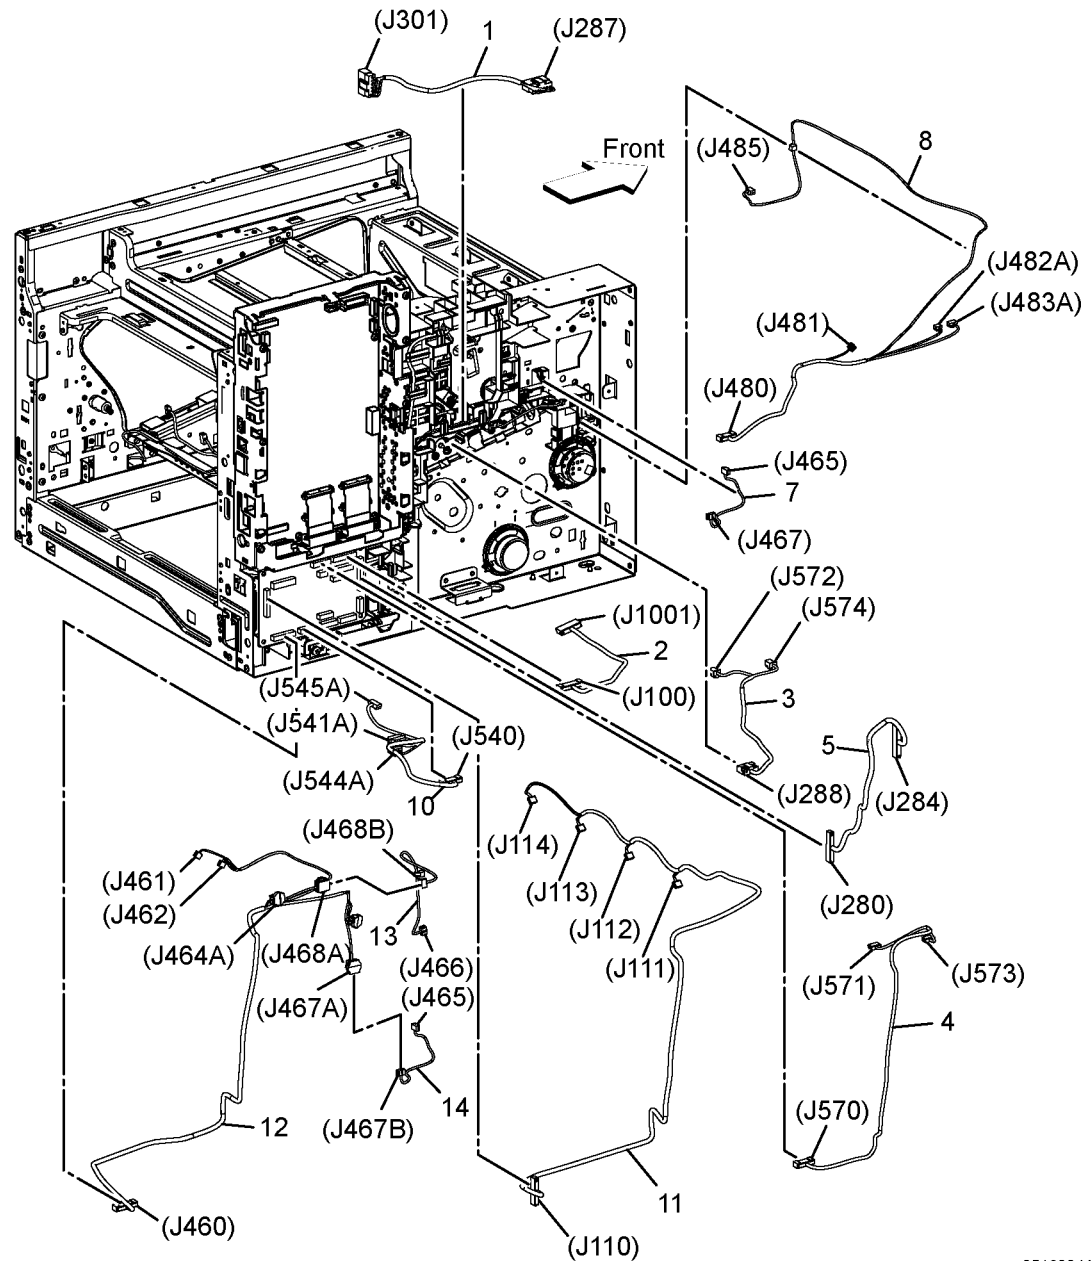
PL 18.4 Electrical MFP (4/4)

Item	Part	Description
1	-	ESS-PWR-C Harness Assy (J287-J301)
2	-	MCU-HVPS-C Harness Assy (J100-J1001)
3	-	Motor Harness Assy (SCC) (J288-J572, J574)
4	-	MCU-MOT-C Harness Assy (J570-J571, J573)
5	-	LV MCU Harness Assy (J280-J284)
6	-	
7	-	SNR DEVE/XERO-C Harness Assy (J467B-J465)
8	-	MSI CL Harness Assy (J480-J482A, J483A, J485)
9	-	
10	-	Regi -C Harness Assy (J540-J541A, J544A, J545A)
11	-	Toner CRUM Harness Assy (J110-J111-J112-J113-J114)
12	-	Deve CL Harness Assy (J460-J468A, J467A, J461, J462, J463A, J464A)
13	-	K-SNR-C Harness Assy (J468B-J466)
14	-	SNR Deve/Xero-C Harness Assy (J467B-J465)

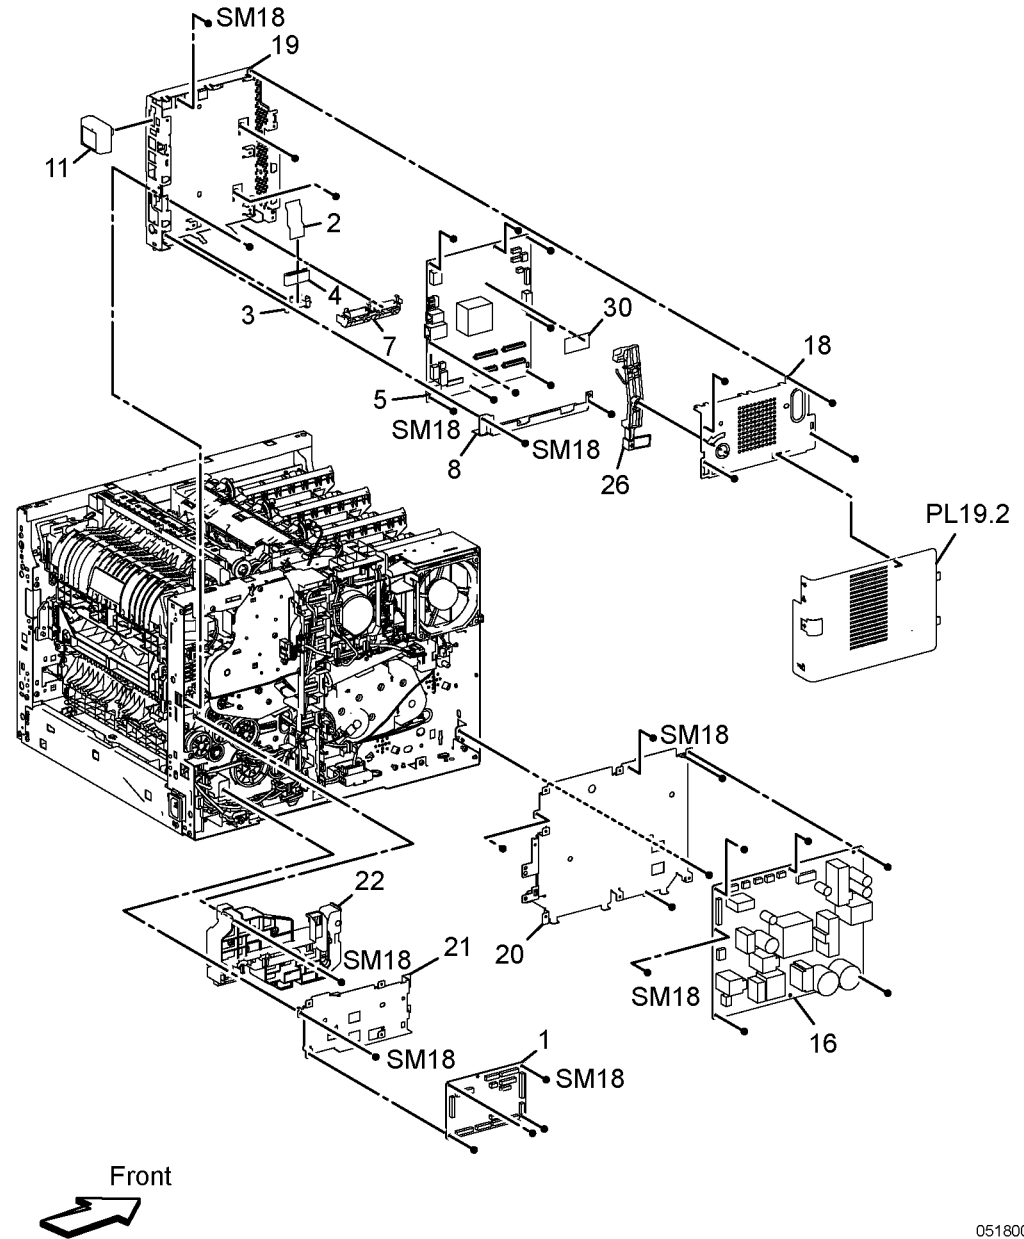
PL 18.5 Electrical SFP (1/4)

Item	Part	Description
1	960K87210	MCU PWBA (SCC)
2	952K22010	MCU ESS FFC Cable
3	-	MCU FFC Color Guide
4	-	MCU Core
5	607K00113	PWBA ESS SFP (SCC) (ISC)
6	-	
7	-	LPH FFC Color Guide
8	-	ESS Low Plate
9	-	
10	-	
11	-	Wireless Module
12	-	
13	-	
14	-	
15	-	
16	105K33011	PWBA LVPS 220V
-	105K33001	PWBA LVPS 110V (SCC)
17	-	
18	-	ESS Top Plate
19	-	ESS Box SFP
20	-	LVPS Plate
21	-	MCU Plate
22	-	PH Drive Housing
23	-	
24	-	
25	-	
26	-	WiFi Link
27	-	
28	-	
29	-	
30	-	EMMC Board

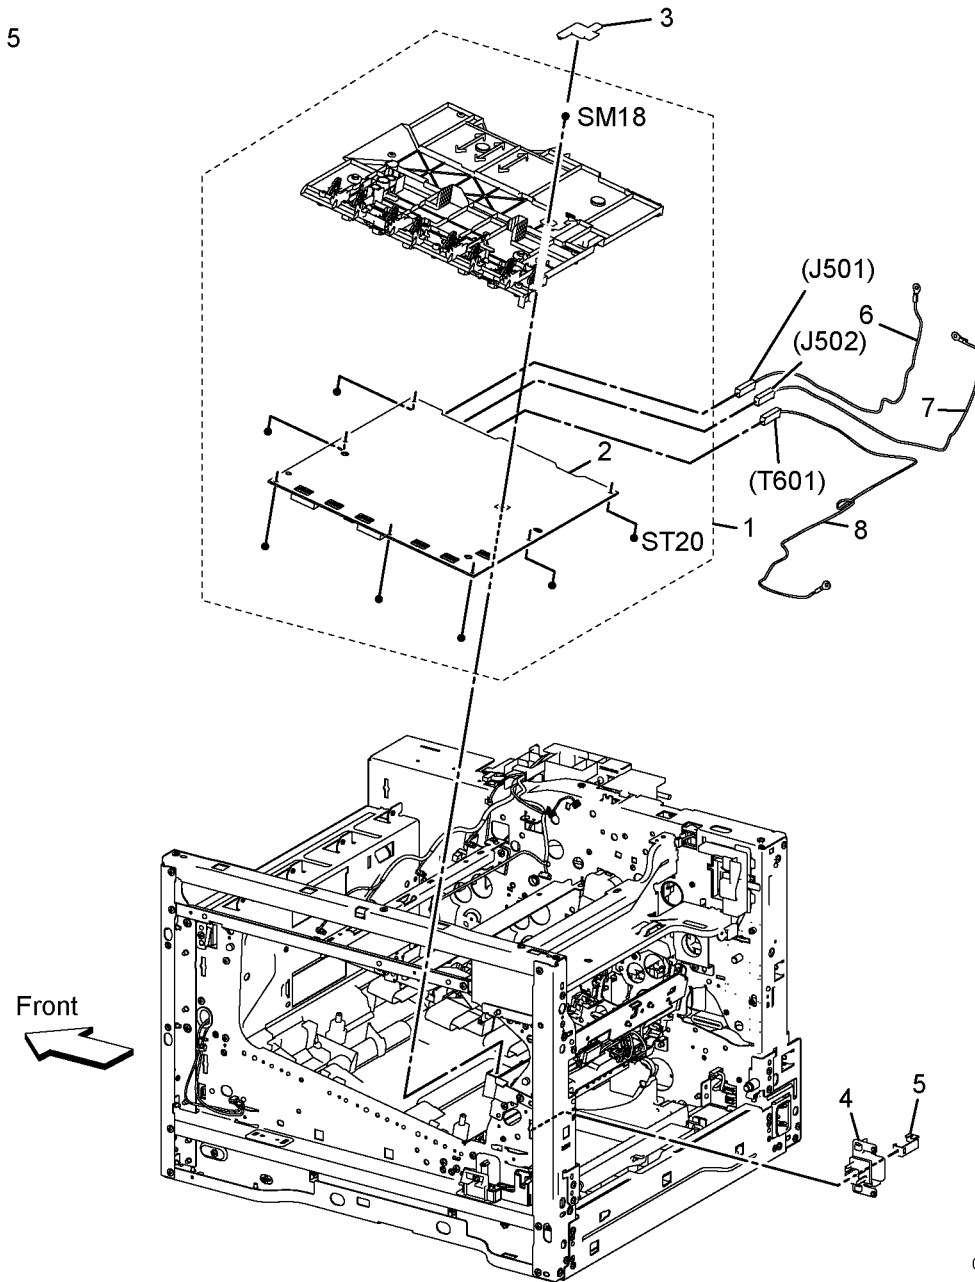
PL 18.6 Electrical SFP (2/4)

Item	Part	Description
1	032K10622	HVPS Guide Assy (With 2)
2	—	HVPS PWBA (SCC) (P/O PL 18.6 Item 1)
3	822E21972	HVPS Toner Cover
4	—	Bias Transfer Roller 2nd Housing
5	—	Bias Transfer Roller 2nd Bias Plate
6	—	1st K Supply Harness Assy (J501)
7	—	1st YMC Supply Harness Assy (J502)
8	—	Trans Supply Harness Assy (T601)
99	604K97510	Kit 2nd Bias Transfer Roll Housing (With 4-5)

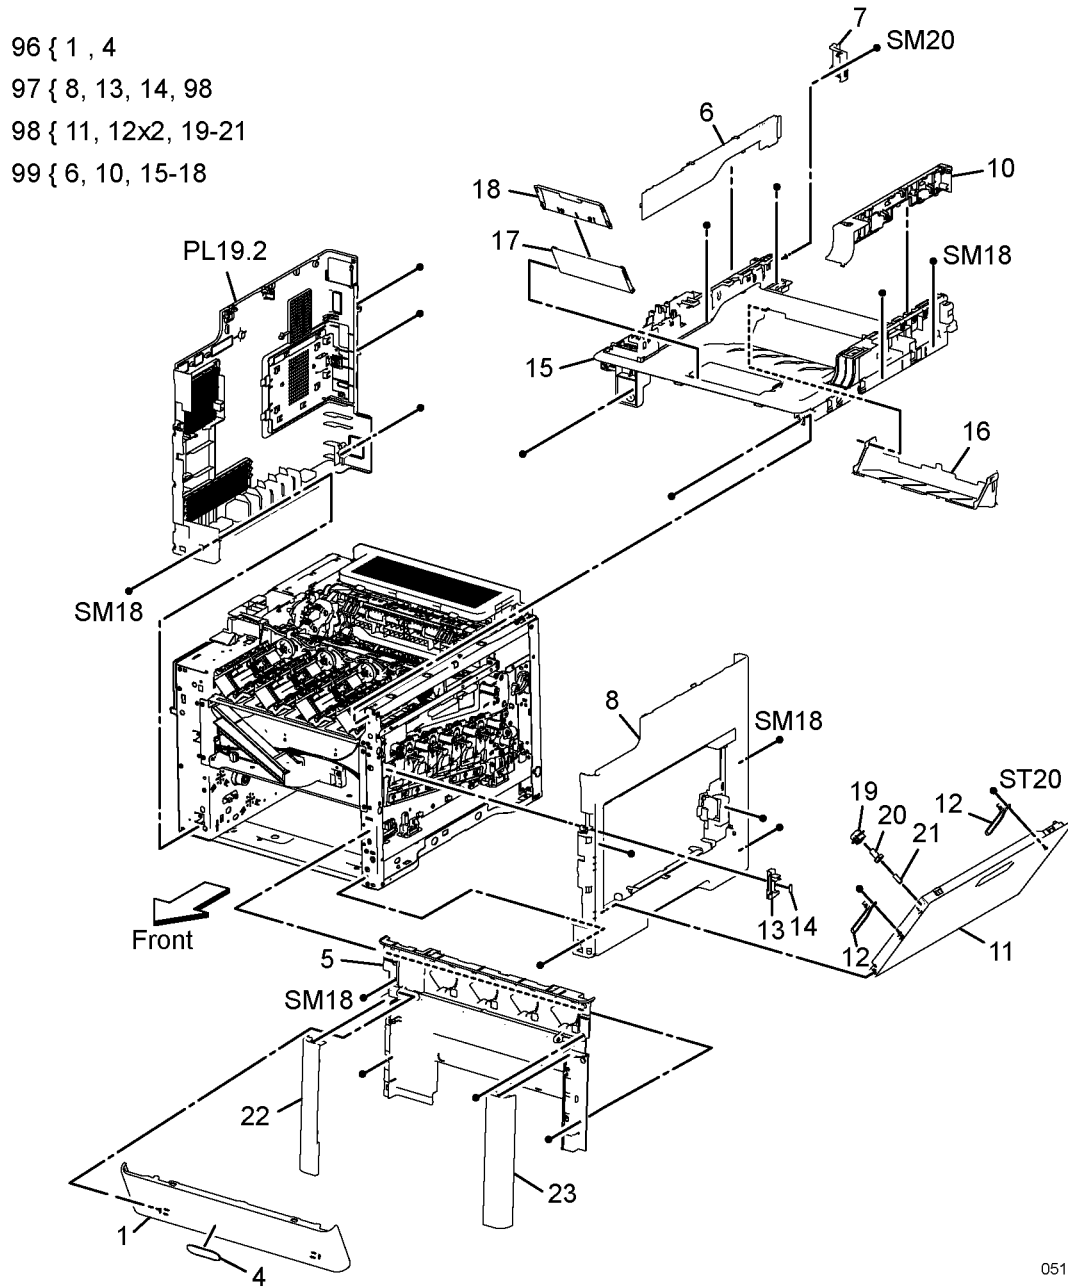
PL 19.1 Cover MFP (1/2)

Item	Part	Description
1	-	Toner Cover
2	-	
3	-	
4	-	Logo
5	948K07510	Front Inner Cover
6	-	Left Inner IIT Cover
7	-	Rear Left Inner IIT Cover
8	-	Right Side Cover
9	-	
10	-	Right Inner IIT Cover
11	-	Waste Cover
12	-	Waste Cover Strap
13	-	Link Waste
14	-	Waste Link Spring
15	-	Top Cover
16	-	Exit Cover
17	-	Extension Tray
18	-	Sub Extension Tray
19	-	Interlock Holder
20	-	Interlock Actuator
21	-	Interlock Spring
22	822E27562	Front Left Cover
23	822E27532	Front Right Cover
96	948K07540	Toner Cover Assy (With 1, 4)
97	948K07581	Right Side Cover Assy (With 8, 13, 14, 98)
98	-	Waste Cover Assy (With 11, 12x2, 19-21)
99	948K00732	Top Cover Assy (With 6, 10, 15-18)
