Phaser® 6510, WorkCentre® 6515 Service Manual

Xerox Phaser 6510 Color Printer/WorkCentre 6515 Color Multifunction Printer

Phaser 6510 Color Printer/WorkCentre 6515 Color Multifunction Printer Service Manual

705P01382

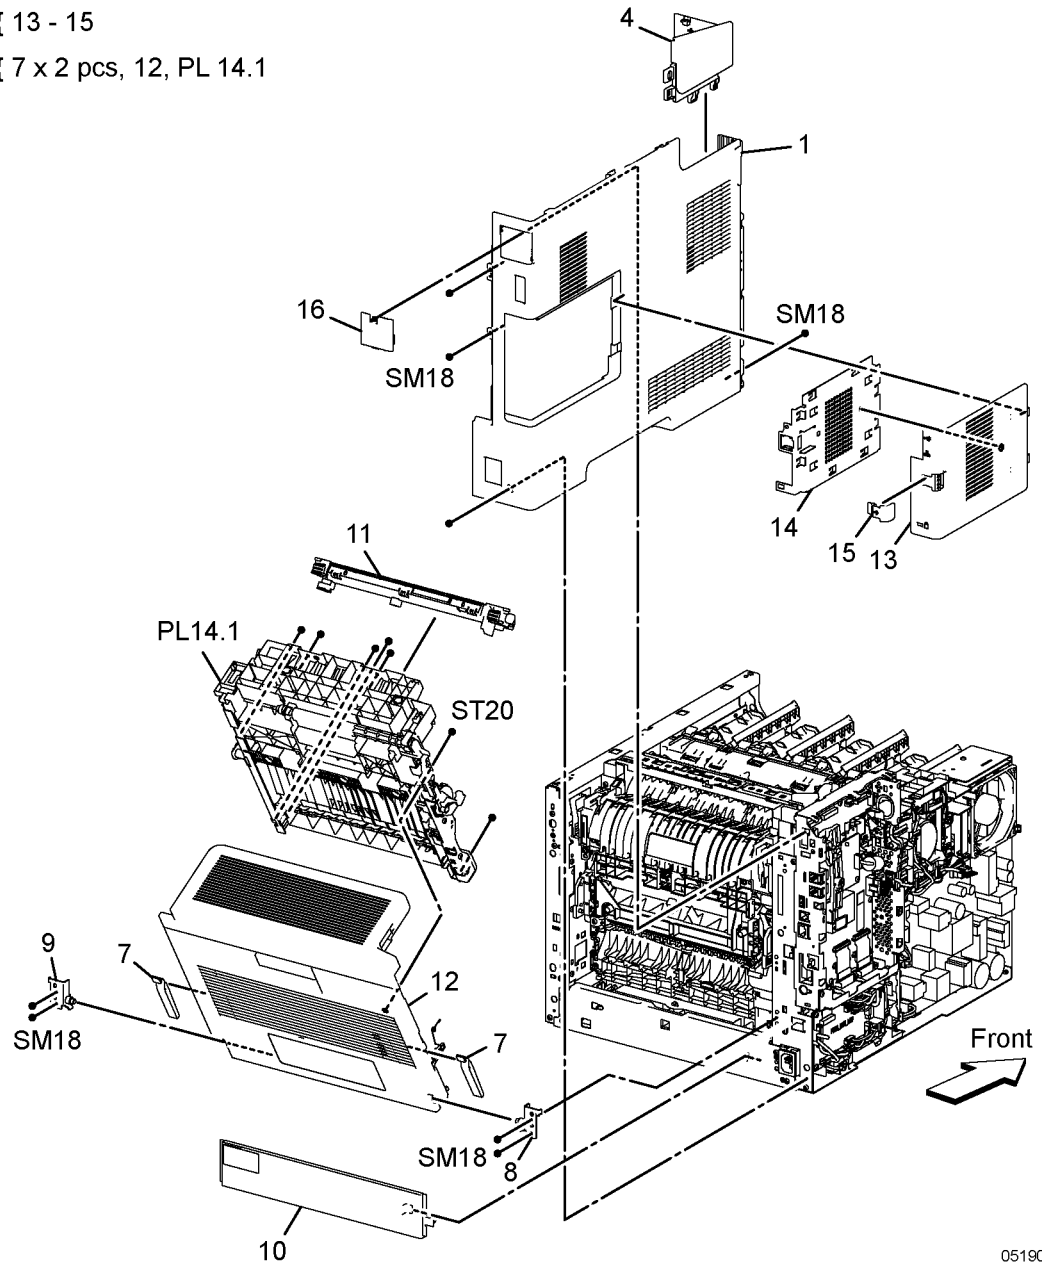
PL 19.2 Cover MFP (2/2)

Item	Part	Description
1	822E27663	Left Side Cover
2	-	
3	-	
4	822E27672	Left Side IIT Cover
5	-	
6	-	
7	-	Rear Cover Strap
8	-	Rear Left Hinge Assy (ACO)
9	-	Rear Right Hinge Assy
10	-	Rear Bottom Cover
11	607K04070	2nd Bias Transfer Roller Assy
12	-	Rear Cover Assy
13	-	ESS Window
14	-	ESS Window Plate
15	-	ESS Window Lever
16	822E27572	Wifi Cap
98	815K16400	Kit ESS Window Assy (With 13-15)
99	607K00480	Kit Rear Cover Assy MFP (with 7x2, 12, PL14.1)

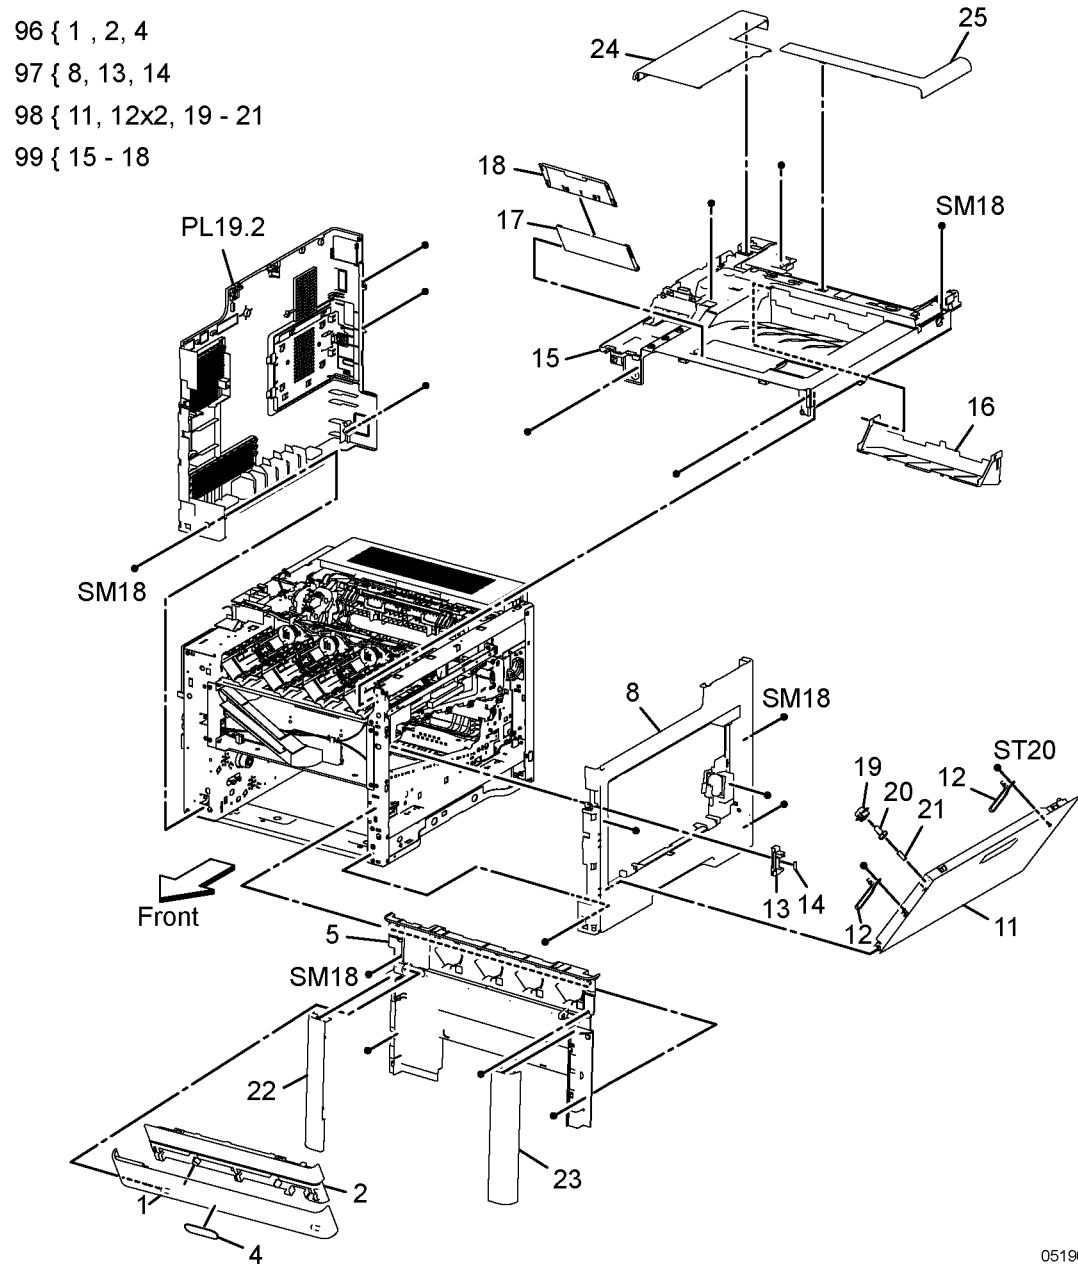
PL 19.3 Cover SFP (1/2)

Item	Part	Description
1	-	Toner Cover
2	-	Top Toner Cover
3	-	
4	-	Logo
5	948K07500	Front Inner Cover
6	-	
7	-	
8	-	Right Side Cover
9	-	
10	-	
11	-	Waste Cover
12	-	Waste Cover Strap
13	-	Link Waste
14	-	Waste Link Spring
15	-	Top Cover
16	-	Exit Cover
17	-	Extension Tray
18	-	Sub Extension Tray
19	-	Interlock Holder
20	-	Interlock Actuator
21	-	Interlock Spring
22	822E27562	Front Left Cover
23	822E27532	Front Right Cover
24	822E40820	Rear Left Top Cover
25	822E22242	Rear Right Top Cover
96	-	Toner Cover Assy (With 1, 2, 4)
97	948K07551	Right Side Cover Assy (With 8, 13, 14)
98	-	Waste Cover Assy (With 11, 12x2-19-21)
99	948K00742	Top Cover Assy (With 15-18)

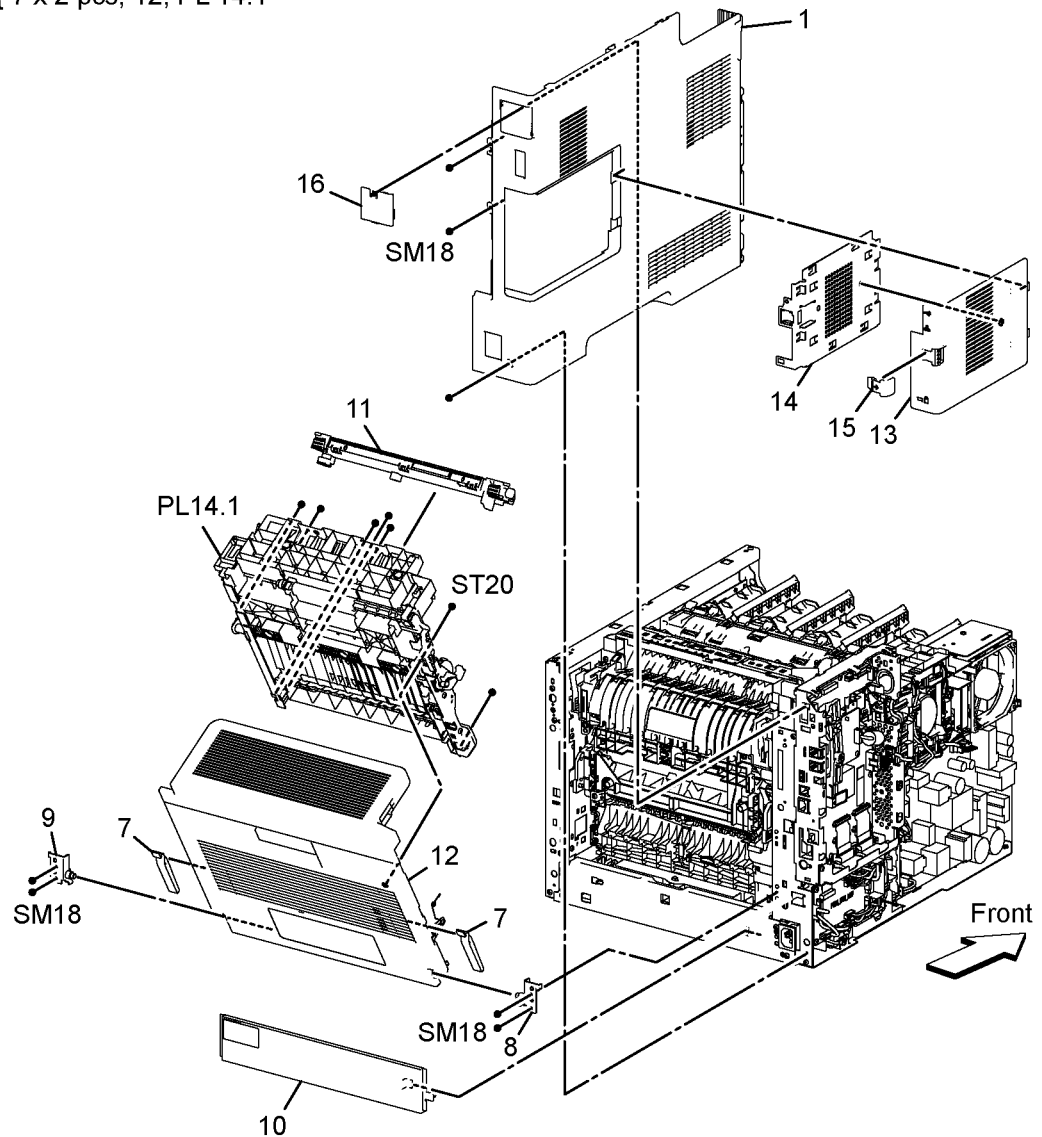
PL 19.4 Cover SFP (2/2)

Item	Part	Description
1	822E27554	Left Side Cover
2	-	
3	-	
4	-	
5	-	
6	-	
7	-	Rear Cover Strap
8	-	Rear Left Hinge Assy
9	-	Rear Right Hinge Assy
10	-	Rear Bottom Cover
11	607K04070	2nd Bias Transfer Roller Assy
12	-	Rear Cover Assy SFP
13	-	ESS Window Assy
14	-	ESS Window Plate
15	-	Lever ESS Window
16	822E27572	Wifi Cap
98	815K16400	Kit ESS Window Assy (With 13-15)
99	607K00500	Kit Rear Cover Assy (with 7x2, 12, PL14.1)

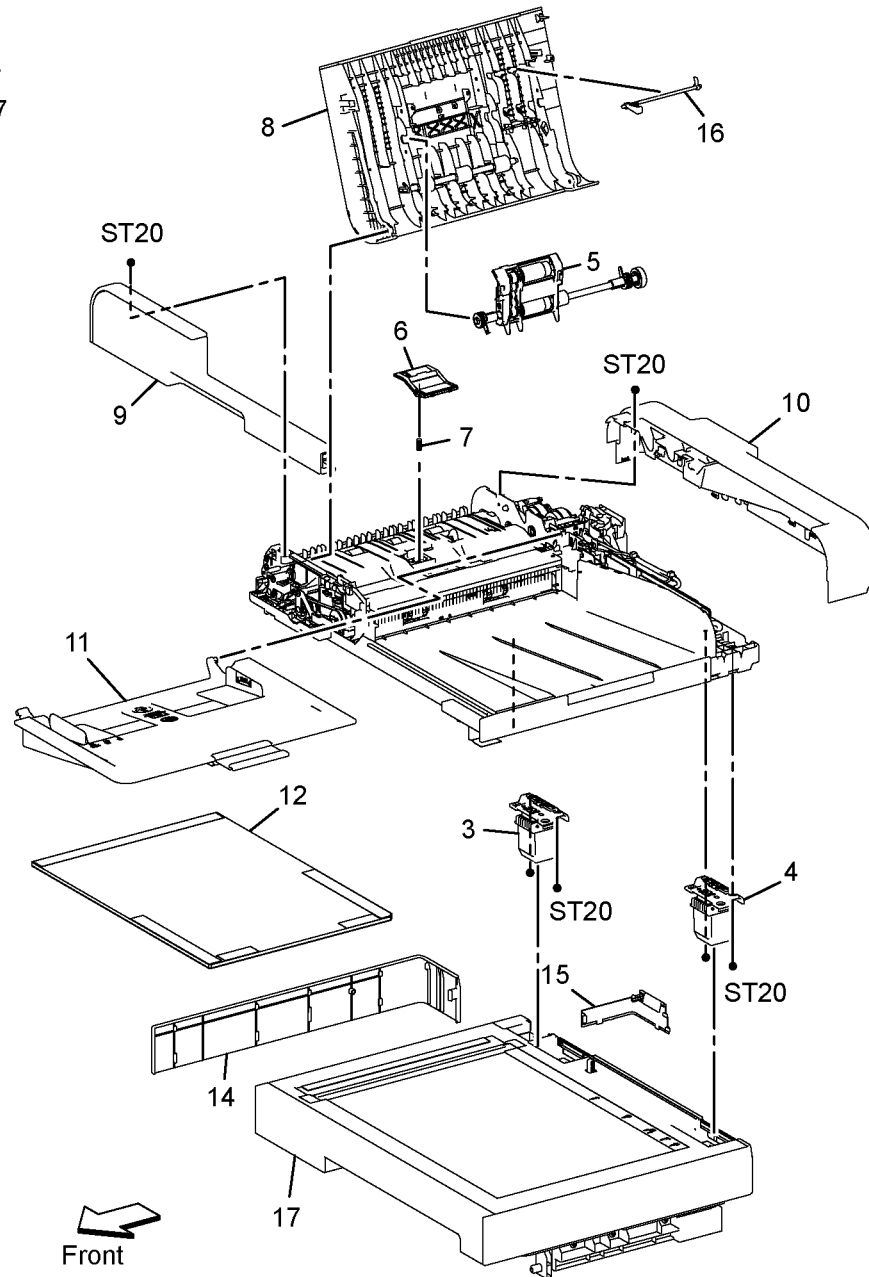
PL 50.1 Scanner

Item	Part	Description	
1	607K04410	DADF Assy (with 3-12, 14)	1 { 3 - 12, 14
2	607K00951	IIT Assy	
3	036K92343	Left Counter Balance Assy	2 { 14, 15, 17
4	036K92323	Right Counter Balance Assy	
5	-	DADF Feeder Roll	13 { 1 - 12
6	-	Separator Cover Assy	
7	-	DADF Separator Spring	99 { 5 - 7
8	-	Upper Feeder Assy	
9	-	DADF Front Cover	
10	-	DADF Rear Cover	
11	050K73592	DADF Tray Assy	
12	-	Platen Cushion Assy	
13	-	Scanner Assy (With 1-12)	
14	-	Left IIT Cover	
15	-	Left Cap IIT Cover	
16	120E35671	DADF Actuator	
17	-	IIT	
99	607K00132	Kit DADF Feed Roll (with 5-7)

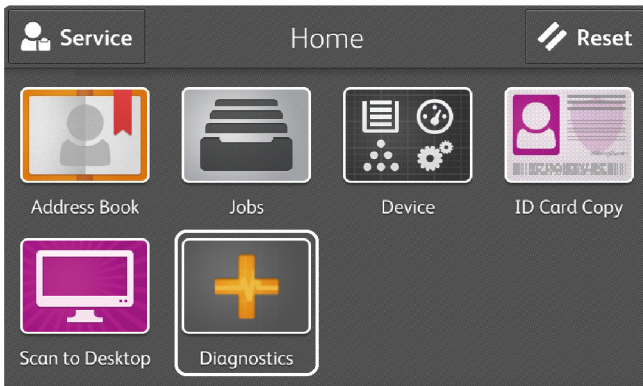
Figure 1 Diagnostics Home Screen

1. Press and hold the **Home** button more than five seconds, then release.
2. Enter the Passcode (6789), and touch **OK**.
3. Touch **Diagnostics**.

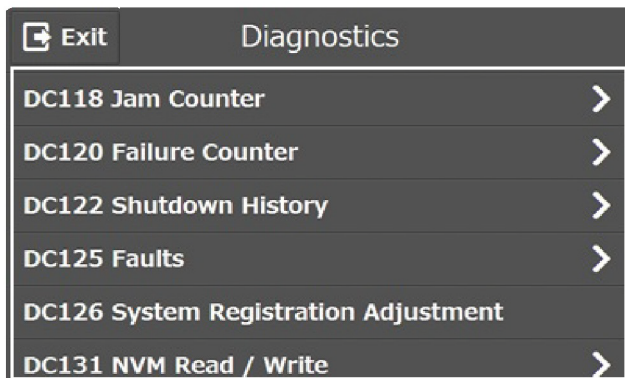
Figure 2 Select from the List of Diagnostics Functions

4. Select the Diagnostics menu.

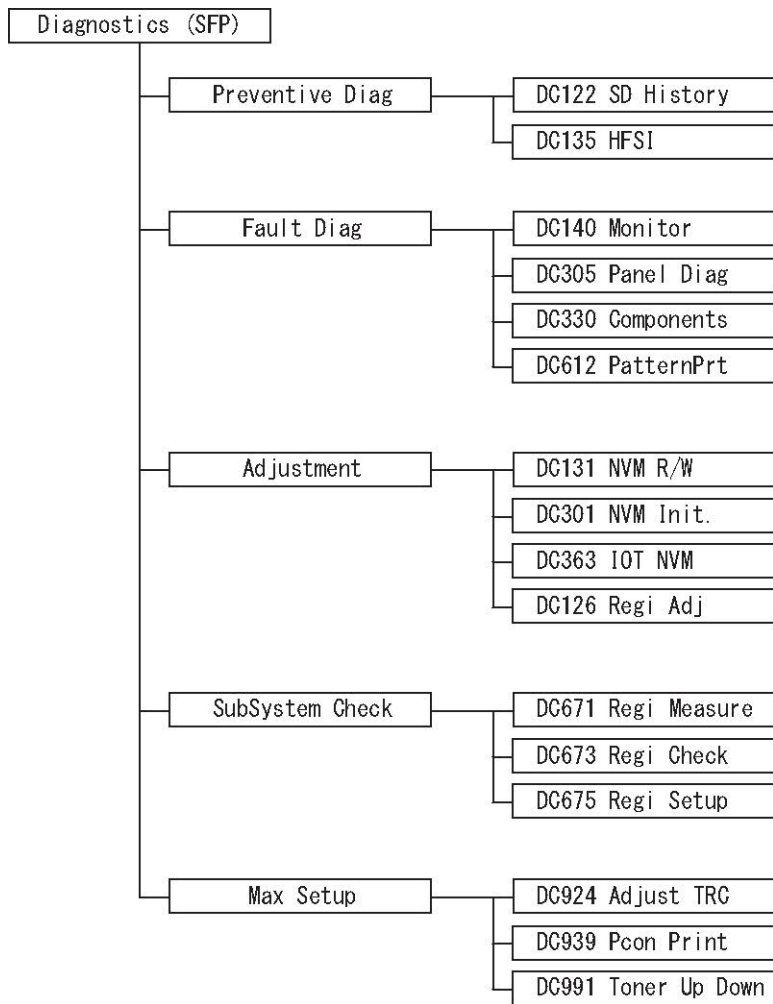
Figure 5 SFP Diagnostics Menu Tree

The Diagnostics menu tree for the SFP is shown in Figure 5.

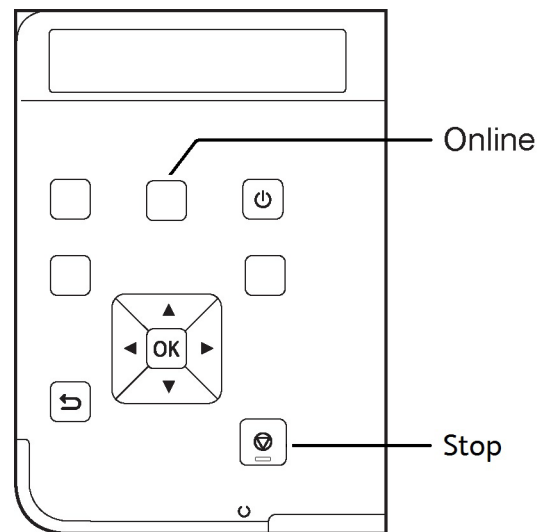
Figure 6 SFP Control Panel

1. Press the Left and Right arrow buttons at the same time.
2. Release the arrow buttons and quickly press **Online** (shown in Figure 6).

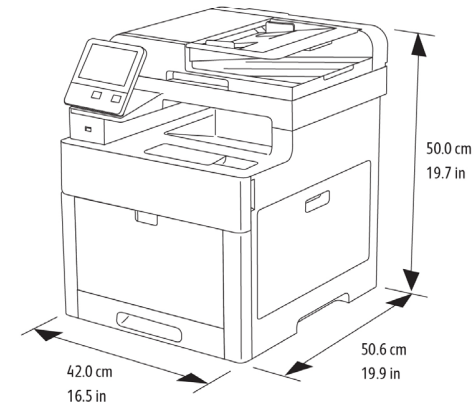
6510_6515-317

Configurations without the Optional 550-Sheet Feeder	All Models with the Optional 550-Sheet Feeder
Width	420 mm (16.5 in.)	420 mm (16.5 in.)
Depth	506 mm (19.9 in.)	506 mm (19.9 in.)
Height	500 mm (19.7 in.)	650 mm (25.6 in.)
Weight	31 kg (68 lb.)	38 kg (84 lb.)

Standard Configuration

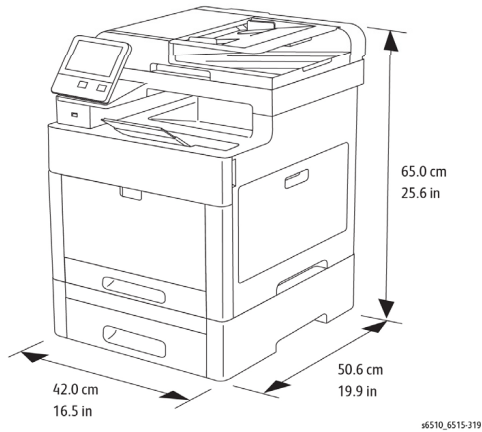
Configuration with Optional 550-Sheet Feeder

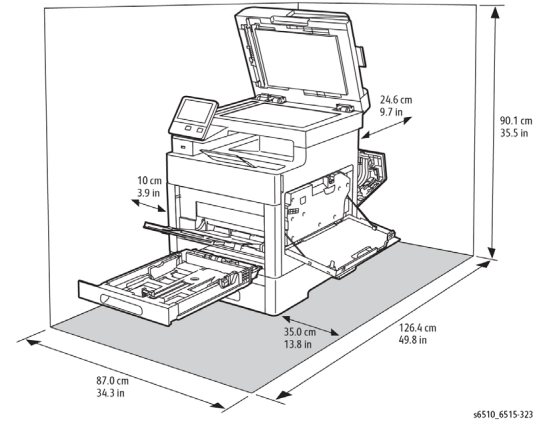
Clearance Requirements with Optional 550-Sheet Feeder

Configurations without the Optional 550-Sheet Feeder	All Models with the Optional 550-Sheet Feeder
Width	870 mm (34.3 in.)	870 mm (34.3 in.)
Depth	1264 mm (49.8 in.)	1264 mm (49.8 in.)
Height	751 mm (29.6 in.)	901 mm (35.5 in.)

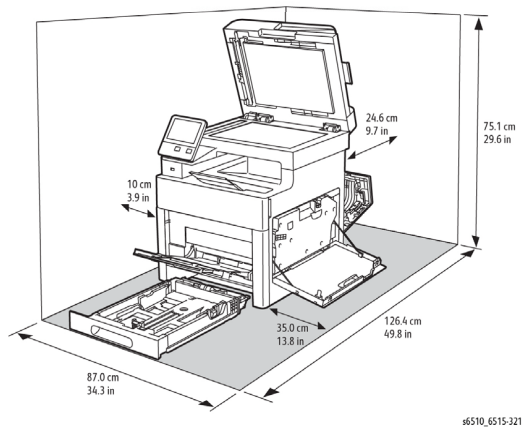
Clearance Requirements

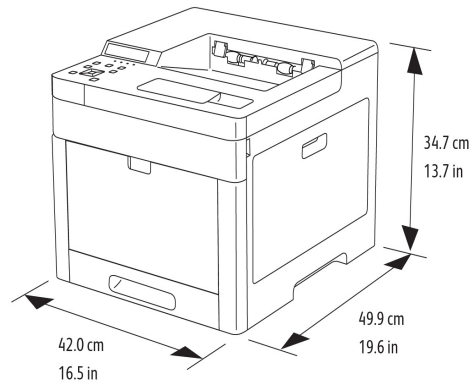
s6510_6515-316

Configurations without the Optional 550-Sheet Feeder	All Models with the Optional 550-Sheet Feeder
Width	420 mm (16.5 in.)	420 mm (16.5 in.)
Depth	499 mm (19.6 in.)	499 mm (19.6 in.)
Height	347 mm (13.7 in.)	497 mm (19.6 in.)
Weight	24 kg (53 lb.)	31 kg (68 lb.)

Standard Configuration

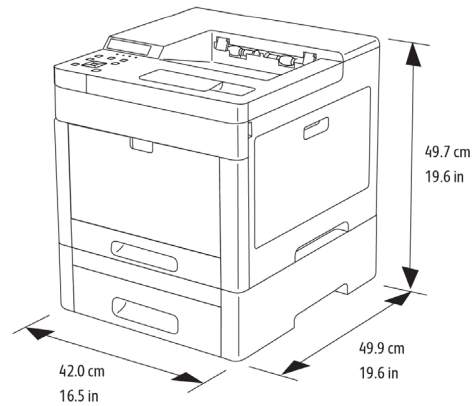
s6510_6515-318

Configuration with Optional 550-Sheet Feeder

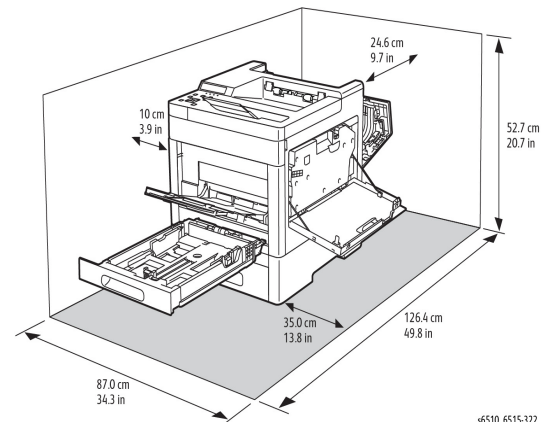
s6510_6515-322

Clearance Requirements with Optional 550-Sheet Feeder

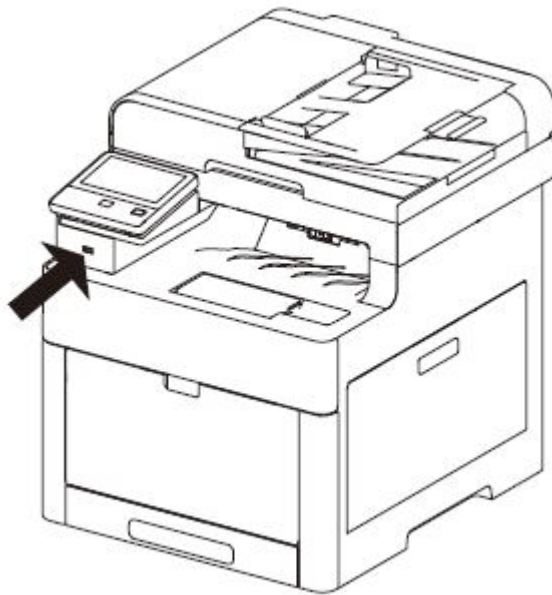
1. With the printer's power off, attach the USB memory device to the printer (Figure 1).

Figure 1 Use the Front USB Connector for Firmware Download

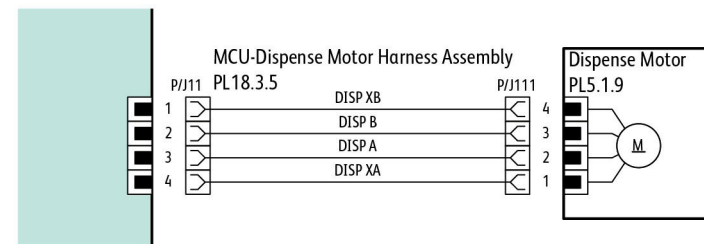
s6655-224

1. Refer to Figure 1 as an example. Disconnect PJ111. Check the +24V supply and the phase pulses to GND when the component control code for the motor is entered. If the supply and pulses are present, install a new motor.
2. Check the connectors and wiring to the motor. Repair or install new wiring, as necessary.
3. Disconnect PJ11. Check the +24V. If +24V is not present, check the power to the PWB. If the power is good, install a new PWB. Check the phase pulses at the PWB. If the phase pulses are not present at the PWB, install a new PWB.

Figure 1 Example Motor Wiring Diagram

NOTE: A stepper motor with an internal open circuit may appear to be fully functional under dC330 component control. However, under normal operation it will run with intermittent failure. Use the multimeter to check stepper motor coil resistance.

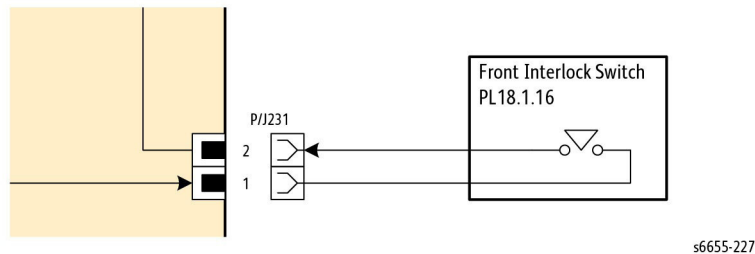
1. Enter dc330 diagnostics and enable the component control code for the switch to test. Actuate the switch. If the display changes, the switch operates correctly. If the display does not change, perform the following steps.
2. Inspect the mechanism intended to actuate the switch. Adjust, repair or replace the part as needed if it is not actuating the switch.
3. Disconnect the switch and measure the resistance between the two connector pins. If it does not change from infinite to 0 ohms as the switch is actuated, replace the switch. If the resistance changes correctly, go to the next step.
4. Check the continuity of the wire harness between the switch and its control PWB. If open, repair or replace the harness.
5. If the switch and wire harness have tested good, replace the PWB that the switch is connected to.

Figure 1 Example Switch Wiring Diagram

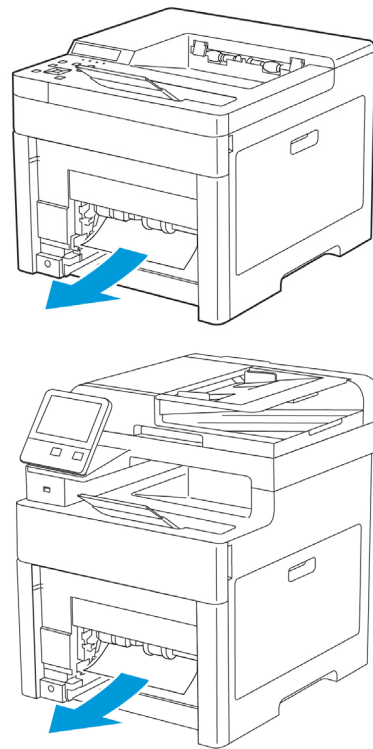
1. Refer to Figure 1 to clear the media path and output trays.

Figure 1 Clear the Media Path and Output Trays

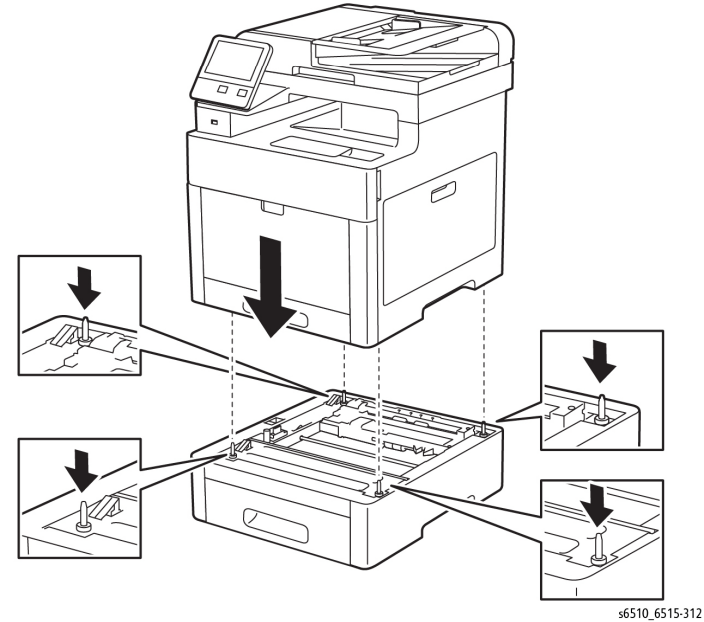
2. Refer to Figure 2 to locate and toggle the slider switch to the unlocked position before separating the printer and optional trays.

Figure 2 Separate Optional Feeder Assembly from the Printer

3. Lift the module to clear the support brackets.
4. Place the module on a suitable work surface to avoid damage.
5. Check the position of the option connector before reassembly.

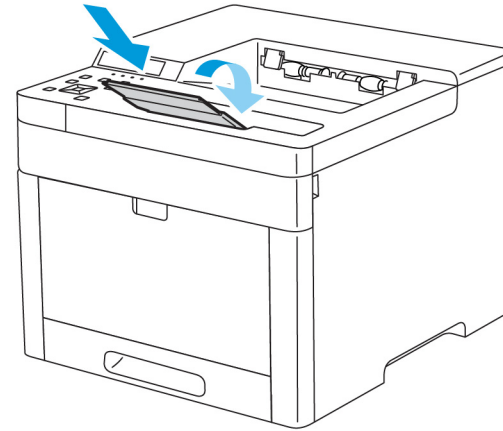
4. Turn off the printer and disconnect the power cord and other cables from the back of the printer.
5. Remove any paper or other media from the output tray. If the output tray extension is extended, close it, Figure 1.

Figure 1 Close the Output Tray Extension

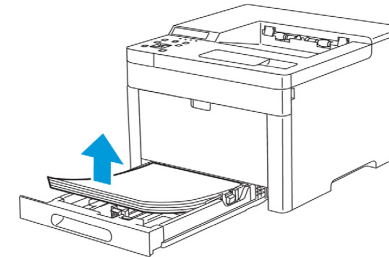
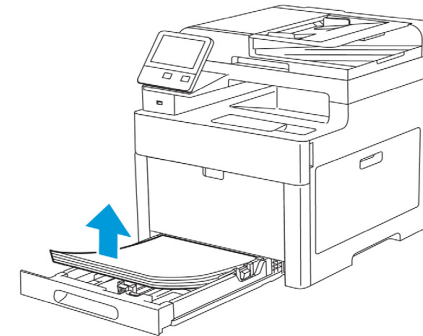
Figure 2 Remove Paper from the Paper Tray

6. Remove the paper from the paper tray, Figure 2. Keep the paper wrapped and away from humidity and dirt.

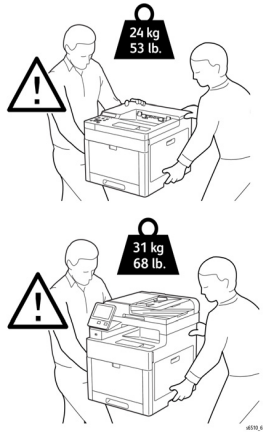
Figure 3 Printer Lifting Technique

7. Lift and carry the printer as shown in Figure 3.

- When moving the printer, do not tilt it more than 10 degrees to the front, back, left, or right. Tilting the printer more than 10 degrees can cause toner spillage.
8. After moving the printer:
- a. Reinstall any parts you removed.
 - b. Reconnect the printer to the cables and power cord.
 - c. Plug in and turn on the printer.

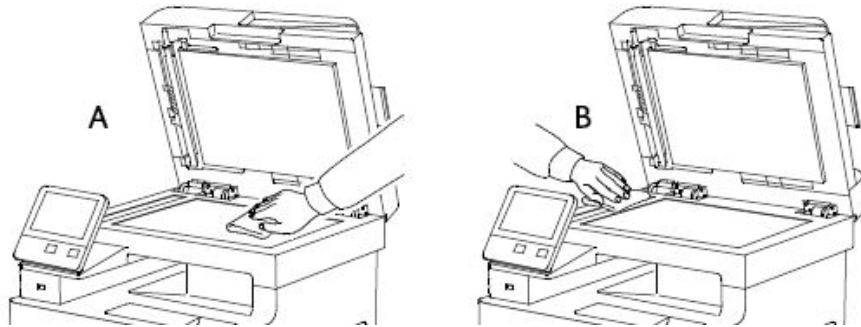
Figure 1 Clean Document Glass and CVT Glass

4. Clean the document glass (A) and the CVT glass (B) to its left (Figure 1).

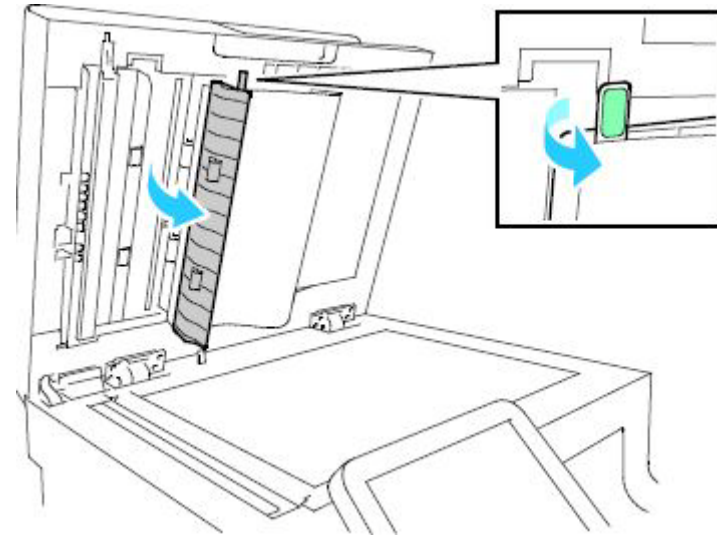
Figure 2 Opening the Second-Side Scanning Access Cover

5. Wipe the white underside of the document cover until it is clean and dry.
6. To access the second-side scanning lens assembly, lower the Second-Side Scanning Access Cover (Figure 2).

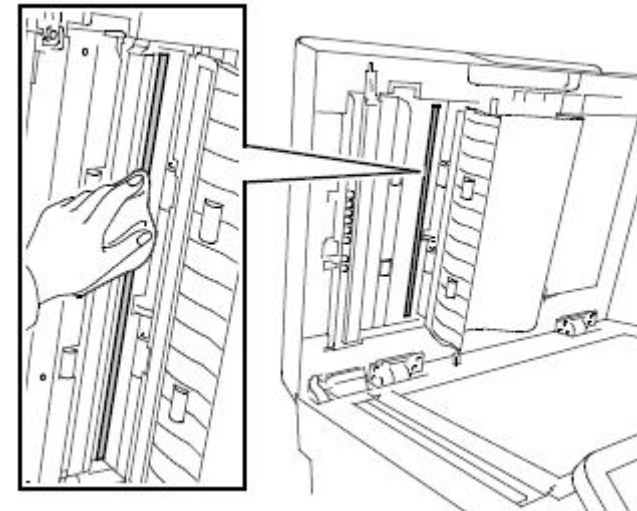
Figure 3 Clean the Second-Side Scanning Lens Assembly

In the following step, to prevent damage to the film around the glass, do not press heavily on the mirrored glass.

7. Using a soft cloth moistened with water, wipe the mirrored glass (Figure 3), the white-plastic strip, and the rollers. If dirt is difficult to remove, moisten a soft cloth with a small amount of neutral detergent. Then wipe the printer parts dry with a soft cloth.

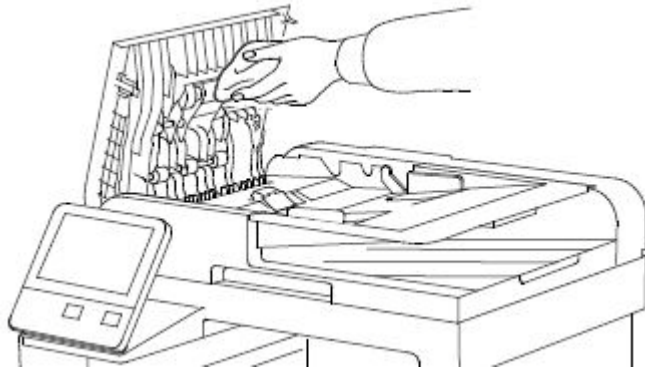
Figure 4 Clean the DADF Feed Rollers

NOTE: If the feed rollers get stained with toner or debris, they can cause stains on the documents. To remove the stains, use a soft lint-free cloth dampened with a neutral detergent or water.

2. Wipe the feed rollers with a dry, soft, lint-free cloth or paper towel until the rollers are clean (Figure 4).

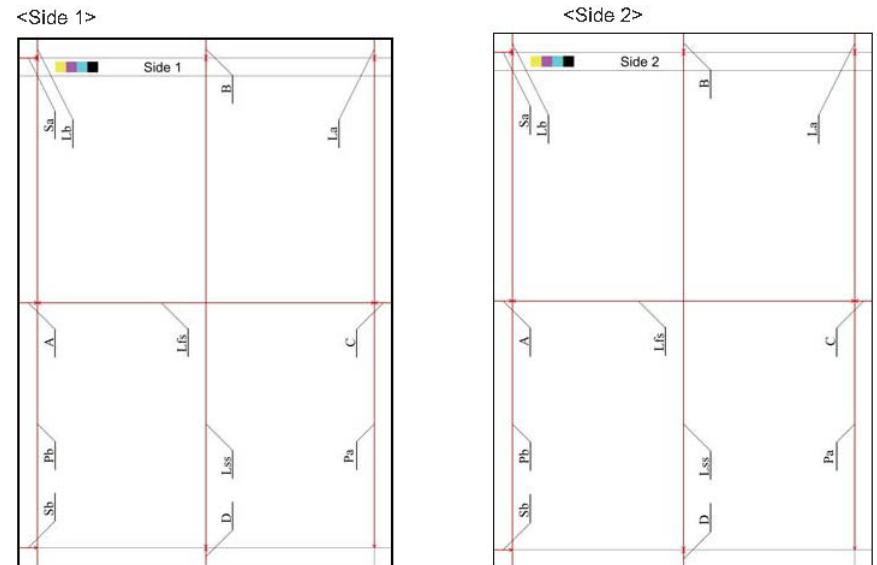
Figure 1 DC126 System Registration Adjustment Test Pattern

1. Enter the Diagnostics, GP 1.
2. Touch **DC126 System Registration Adjustment**.
The **System Registration Adjustment** screen is displayed.
3. Select **Paper Supply**, then choose the adjusting tray.
4. Select **Printout Settings**, then touch **Print**. to print the test pattern (Figure 1).

NOTE: The A, B, C and D locations marked on the test pattern indicate the distance from the test pattern image to the paper's edge.

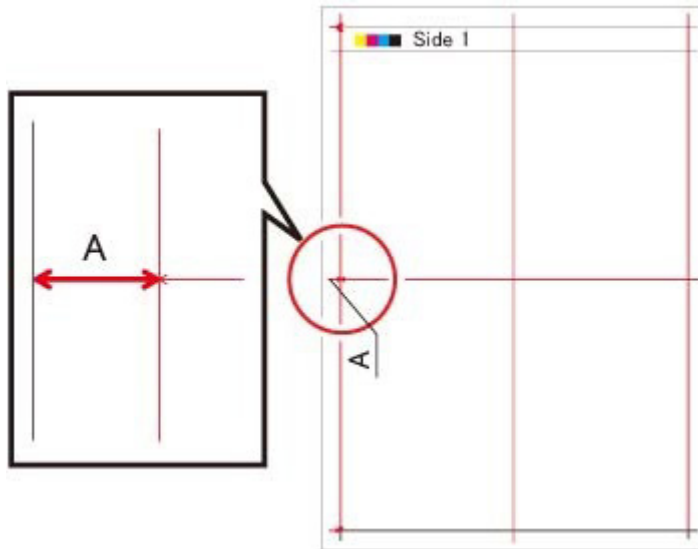
- Using the test pattern chart which was output from the tray requiring adjustment, measure the length (in millimeters) of "A" on the printed test pattern Side 1.

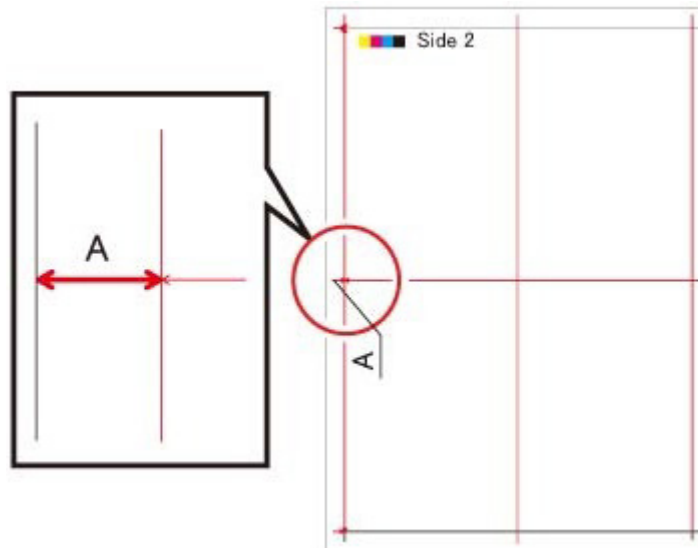
- Measure the length (in millimeters) of "A" on the printed test pattern Side 2.

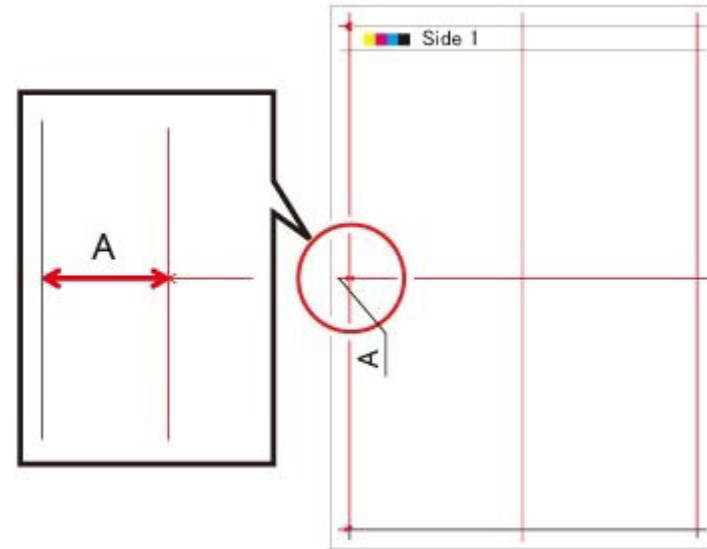
1. Using the test pattern chart which was output from the tray requiring adjustment, measure the length (in millimeters) of "A" on the printed test pattern Side 1.

NOTE: The A, B, C and D locations marked on the test pattern indicate the distance from the test pattern image to the paper's edge.

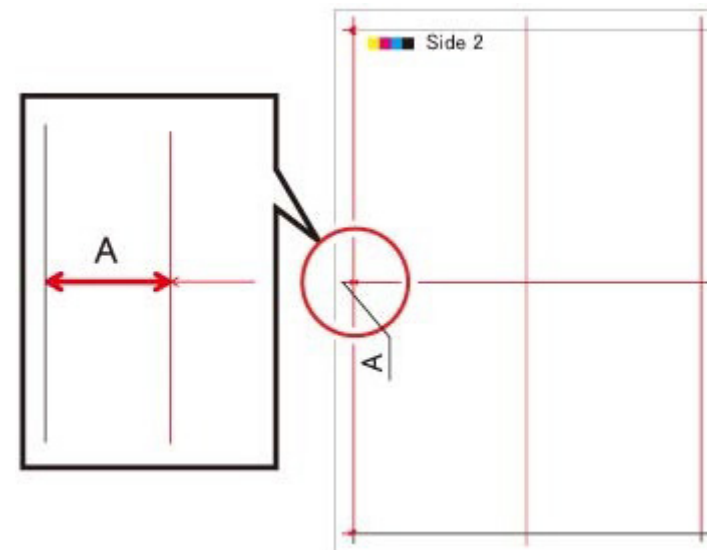
2. Measure the length (in millimeters) of "A" on the printed test pattern Side 2.

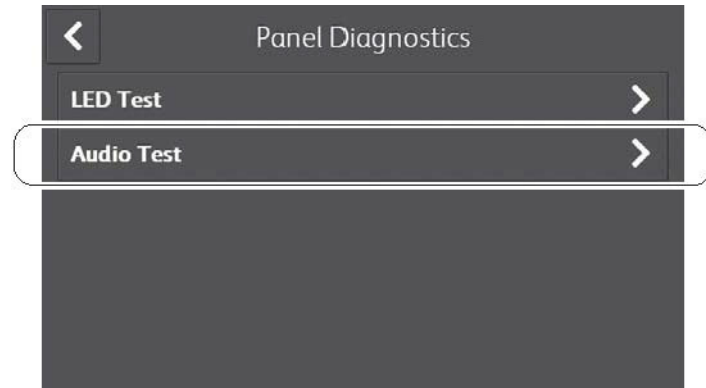
1. Touch **Audio Test**.

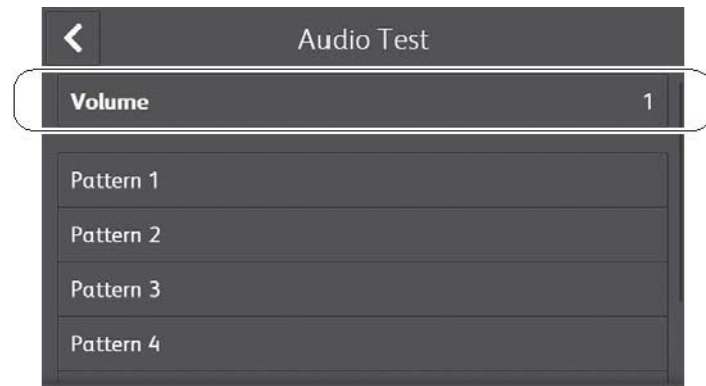
2. Specify the audio volume (three steps).

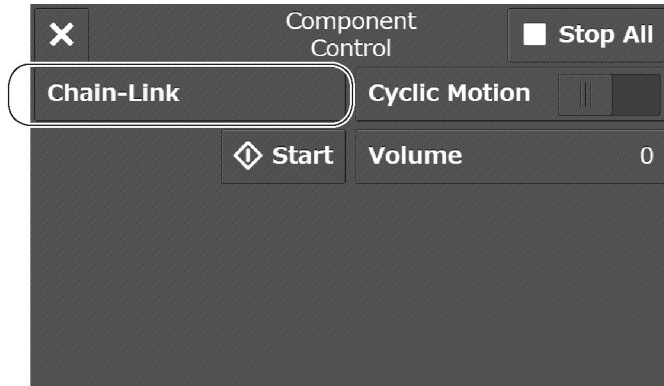
3. Touch **Chain-Link**.

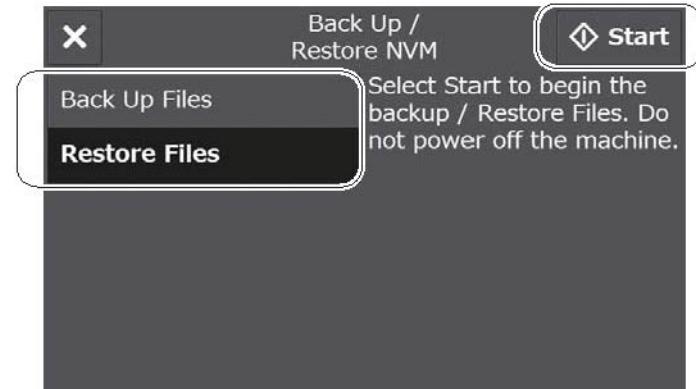
1. Enter the Diagnostics, GP 1.
2. Touch **DC363 NVM Backup Restore**.
The **NVM Backup Restore** screen is displayed.
3. Touch **Back Up Files** or **Restore Files** and touch **Start**.

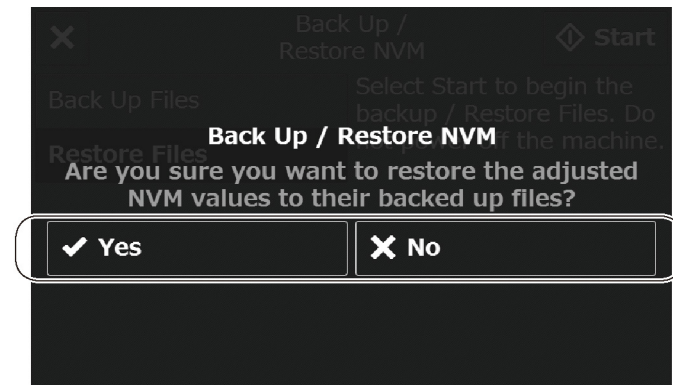
4. Follow the message shown on the **Back Up / Restore NVM** screen and touch **Yes** or **No**.

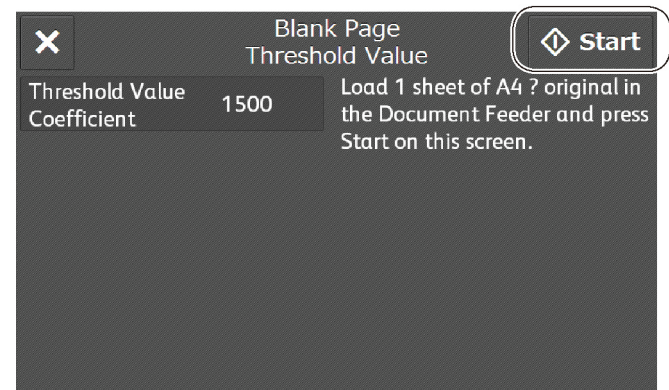
1. Enter the Diagnostics, GP 1.
2. Touch **DC500 Blank Page Threshold Value**.
The **Blank Page Threshold Value** screen is displayed.
3. Follow the message and place a blank sheet of paper (A or A4) on the DADF.
4. Touch **Start**.

5. The DADF does a one-sided scan, the **Threshold Value Coefficient** is displayed and set.
6. Touch **X** to return to the **Diagnostics** screen.
7. Exit the Diagnostics, GP 1.

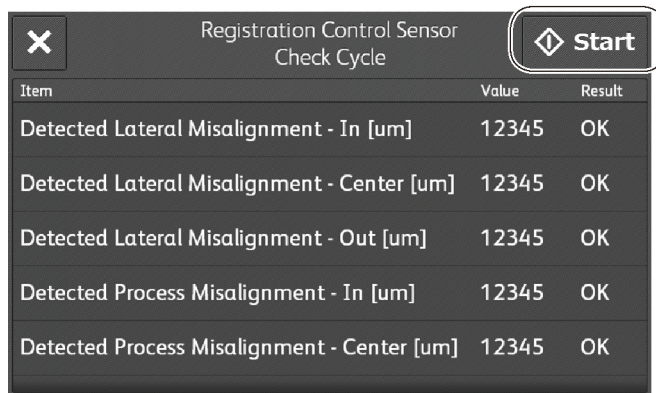
Item	Value	Result
Detected Lateral Misalignment - In [um]	12345	OK
Detected Lateral Misalignment - Center [um]	12345	OK
Detected Lateral Misalignment - Out [um]	12345	OK
Detected Process Misalignment - In [um]	12345	OK
Detected Process Misalignment - Center [um]	12345	OK

- Performs registration measurement to determine the condition of the AC control.
- Checks that the Belt control, etc. are operating normally.
- Measures/displays the amount of color shift relative to Black in the Fast Scan/Slow Scan direction.
- Displays the result of comparing **OK/NG** with the target value.

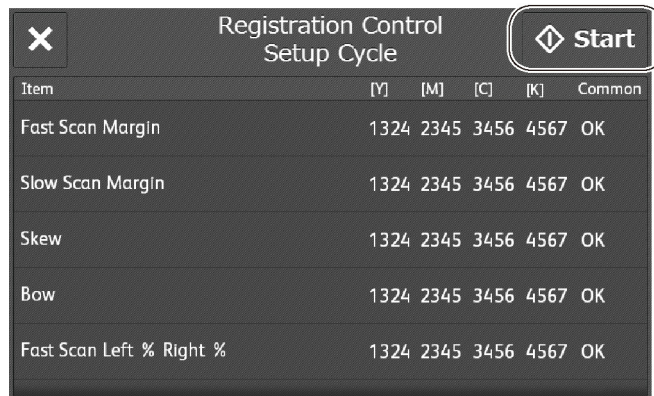
1. Enter the Diagnostics, GP 1.
2. Touch **DC675 Registration Control Setup Cycle**.
The **Registration Control Setup Cycle** screen is displayed.
3. Touch **Start**. The shift amount for each color is corrected automatically.

Item	[Y]	[M]	[C]	[K]	Common
Fast Scan Margin	1324	2345	3456	4567	OK
Slow Scan Margin	1324	2345	3456	4567	OK
Skew	1324	2345	3456	4567	OK
Bow	1324	2345	3456	4567	OK
Fast Scan Left % Right %	1324	2345	3456	4567	OK

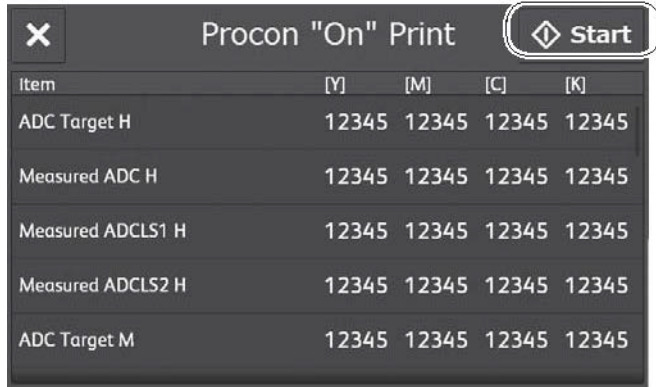
4. Load paper into Tray 1 and touch **Start**.
One sheet of the built-in PG **Pcon PG** is output and the execution result is displayed.

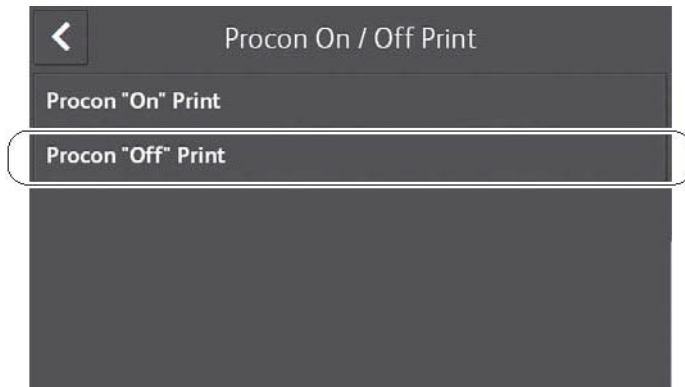
1. Enter the Diagnostics, GP 1.
2. Touch **DC939 Procon On / Off Print**.
The **Procon On / Off Print** screen is displayed.
3. Touch **Procon-Off Print**.

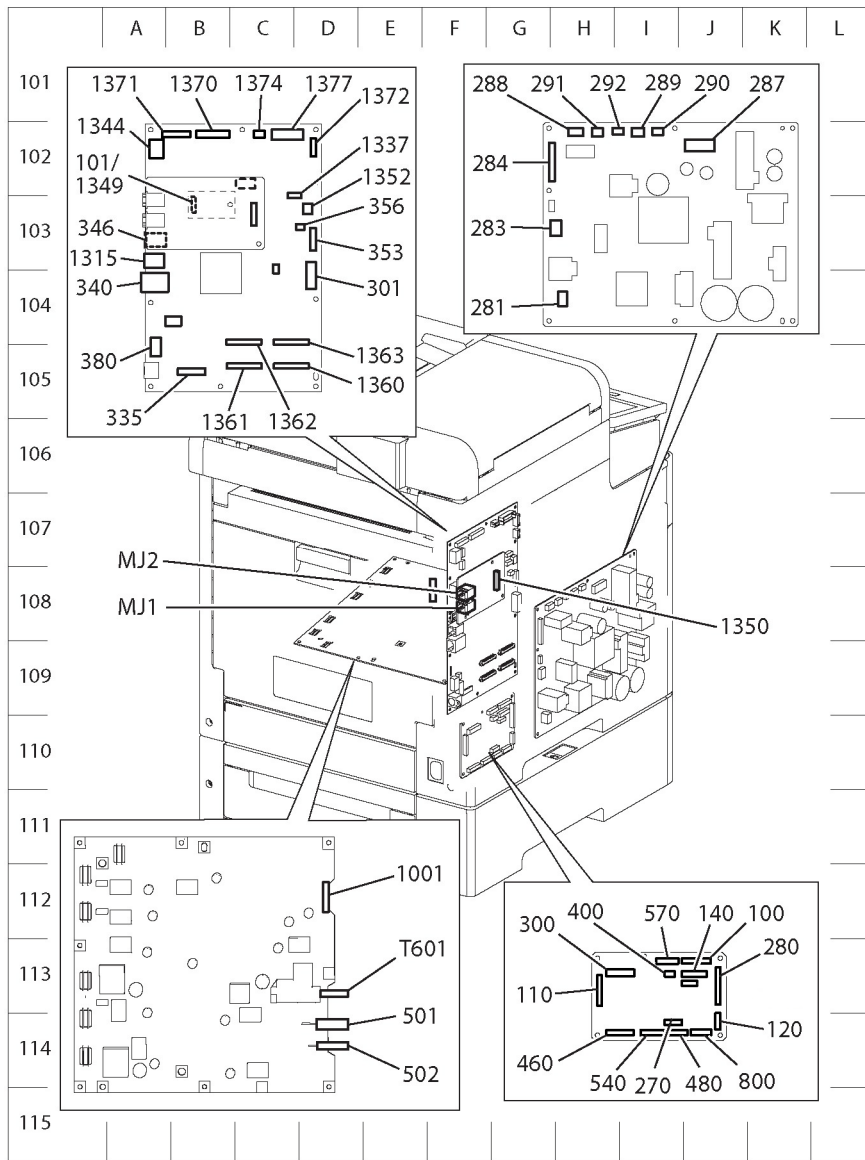
s6510_6515-175b

Figure 1 MFP P/J Locator Map 1

P/J	Map	Coordinates	Connection
815	Figure 5	I-172	550 OPF Board and Feeder Drawer Harness Assembly
816	Figure 5	H-168	H/A Feeder Drawer and Feeder Drawer Harness Assembly
1001	Figure 1	D-112	HVPS Board and MCU-HVPS-C Harness Assembly
1315	Figure 1	A-103	MFP ESS Board and USB 3.0 Device
1337	Figure 1	C-102	MFP ESS Board and Front USB Harness Assembly
1344	Figure 1	A-102	MFP ESS Board and Wireless Module
1349	Figure 1	B-103	MFP ESS Board and EMMC Board
1350	Figure 1	G-108	FAX Board and FAX Harness Assembly
1352	Figure 1	C-102	MFP ESS Board and UI Harness
1360	Figure 1	C-105	MFP ESS Board and LPH Color (Y) Head Assembly
1361	Figure 1	C-105	MFP ESS Board and LPH Color (M) Head Assembly
1362	Figure 1	C-104	MFP ESS Board and LPH Color (C) Head Assembly
1363	Figure 1	C-105	MFP ESS Board and LPH Color (K) Head Assembly
1370	Figure 1	B-102	MFP ESS Board and IIT Assembly
1371	Figure 1	B-102	MFP ESS Board and DADF Assembly

1372	Figure 1	D-102	MFPESS Board and IIT Assembly
1374	Figure 1	C-102	MFP ESS Board and IIT Assembly
1377	Figure 1	C-102	MFP ESS Board and DADF Assembly
MJ1	Figure 1	F-108	Network Cable and FAX Board
MJ2	Figure 1	F-108	Network Cable and FAX Board
T601	Figure 1	D-113	HVPS Board and Trans Supply Harness Assembly

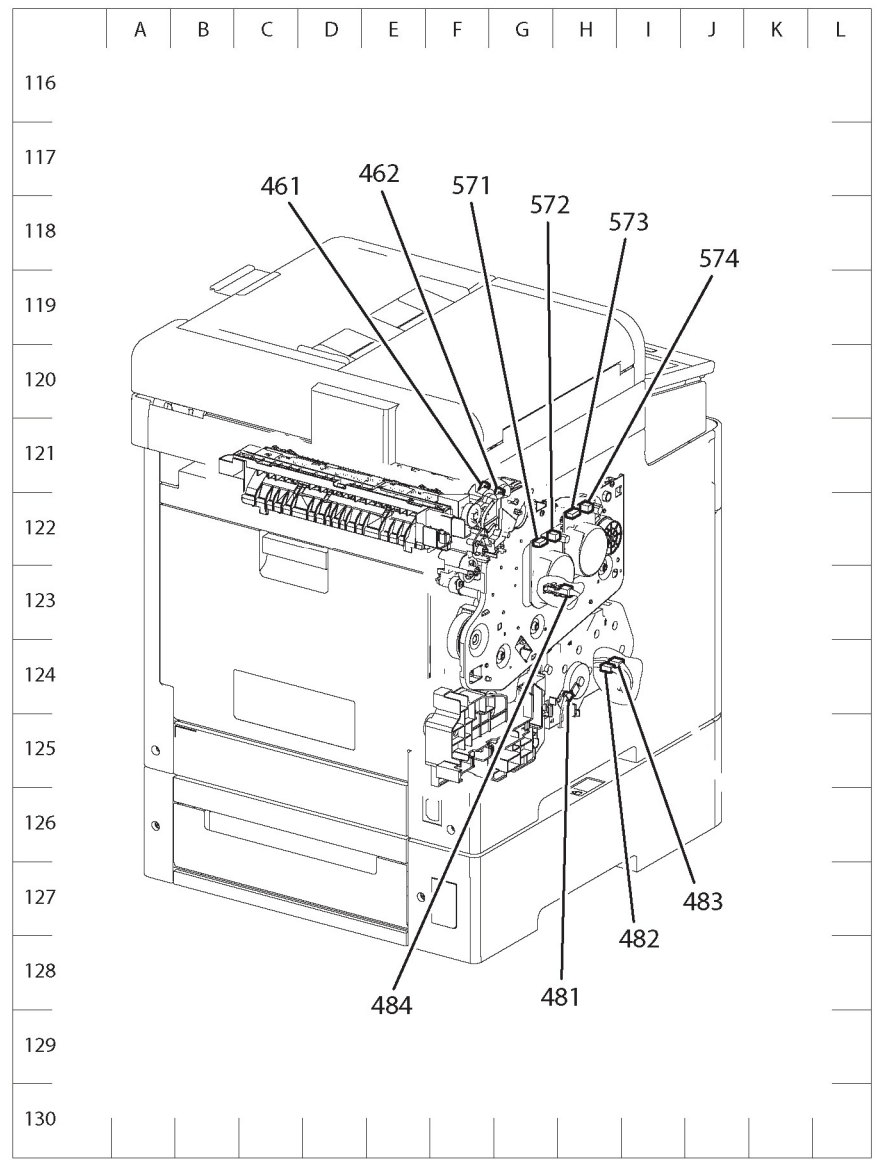
s6510_6515-176b

Figure 2 MFP P/J Locator Map 2

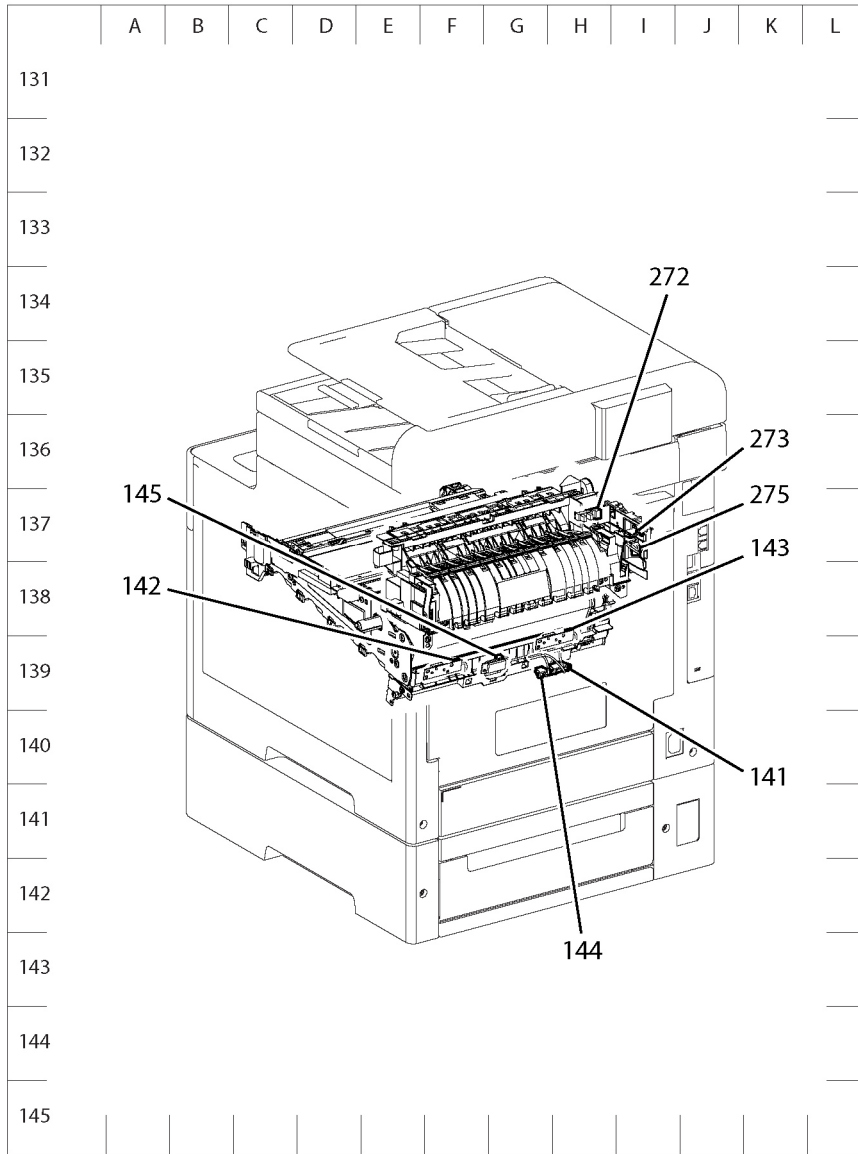
s6510_6515-177

Figure 3 MFP P/J Locator Map 3

143	Figure 3	H-139	R-RAD Sensor and CTD Harness Assembly
144	Figure 3	G-139	Humidity Harness Assembly and Humidity RAD Harness Assembly
145	Figure 3	G-139	Humidity & Temperature Sensor and Humidity Harness Assembly
270	Figure 1	I-114	MCU Board and DC Fuser Harness
272	Figure 3	H-137	Exit Sensor and DC Fuser Harness
273	Figure 3	I-137	Fuser Assembly and DC Fuser Harness
275	Figure 3	I-137	Fuser Assembly and AC Fuser Harness
