Phaser® 6510, WorkCentre® 6515 Service Manual

Xerox Phaser 6510 Color Printer/WorkCentre 6515 Color Multifunction Printer

Phaser 6510 Color Printer/WorkCentre 6515 Color Multifunction Printer Service Manual

705P01382

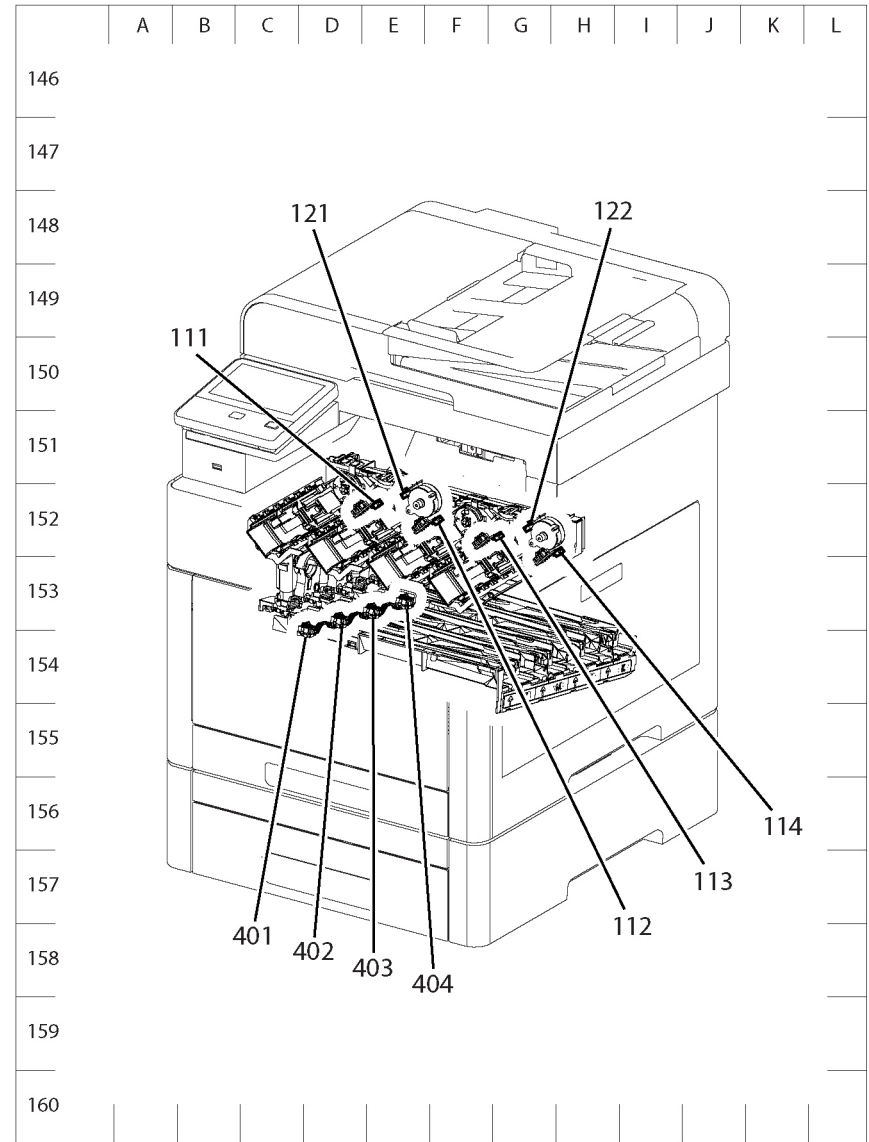
s6510_6515-178

Figure 4 MFP P/J Locator Map 4

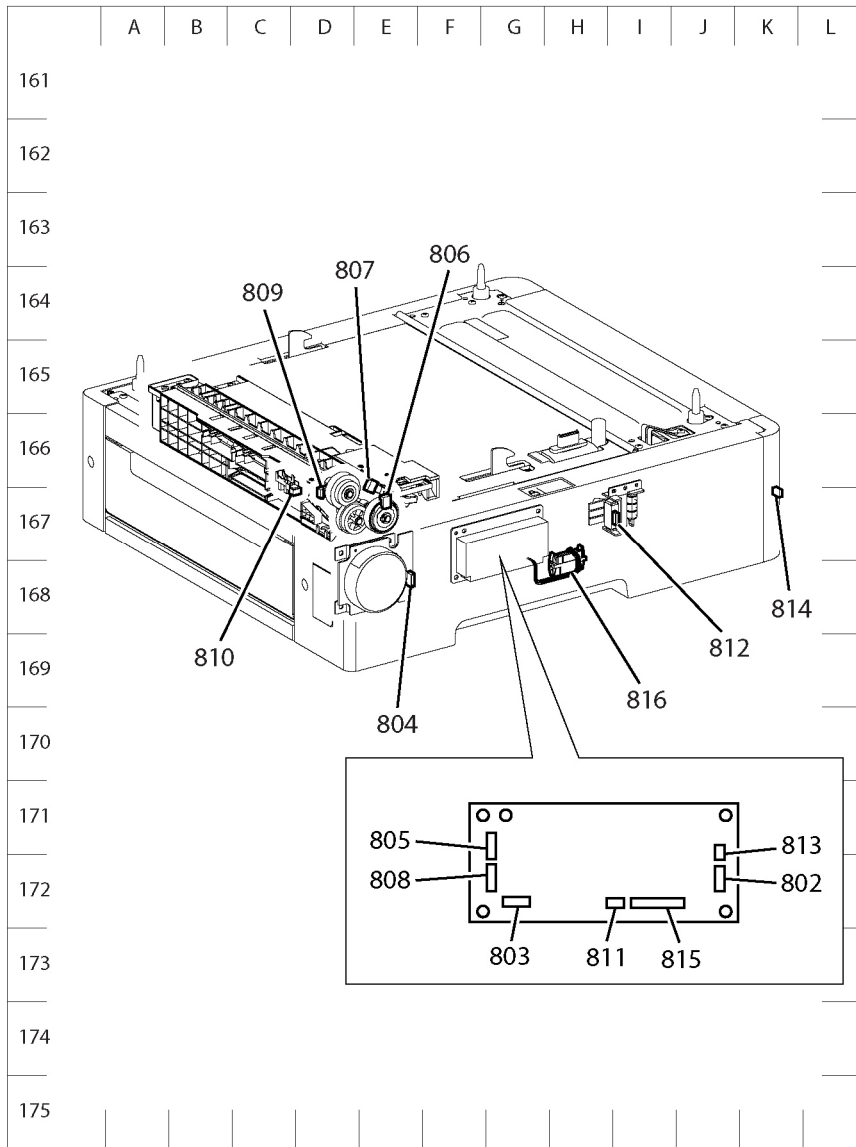
s6510_6515-179

Figure 5 MFP P/J Locator Map 5

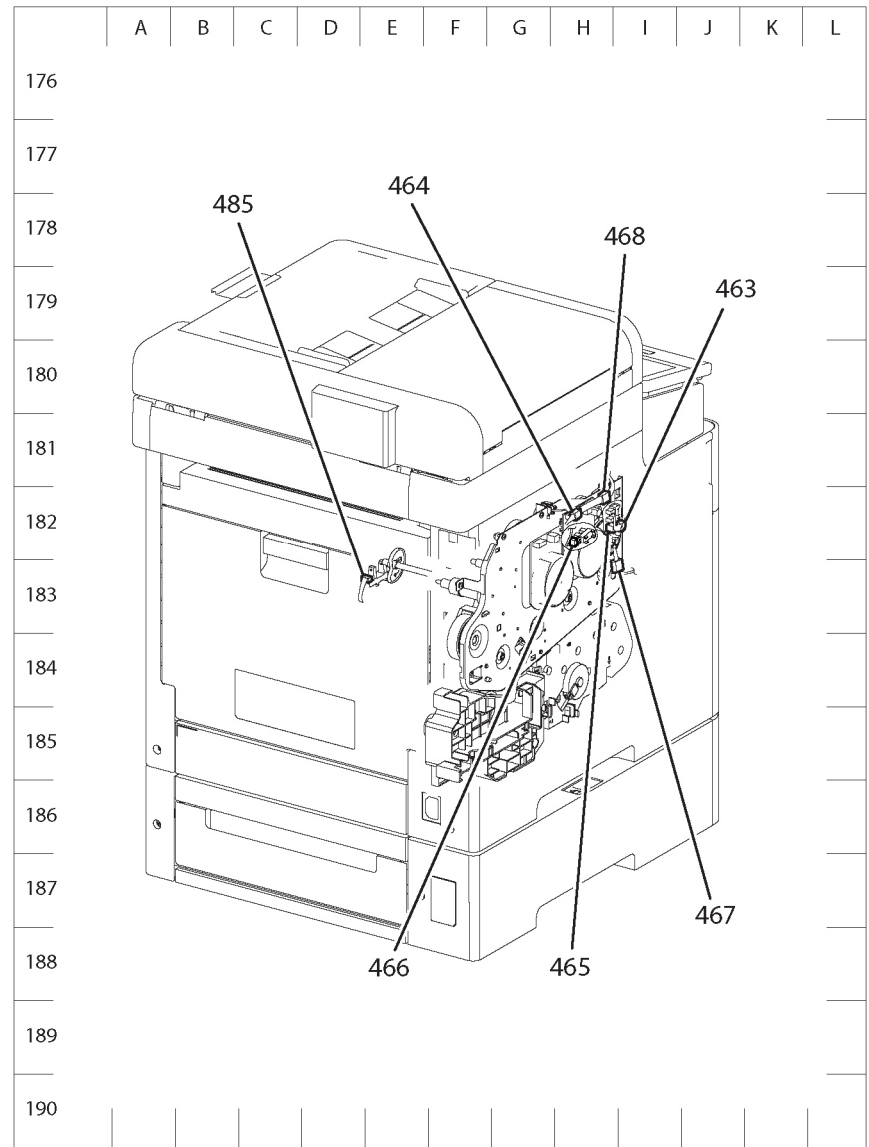
s6510_6515-180

Figure 6 MFP P/J Locator Map 6

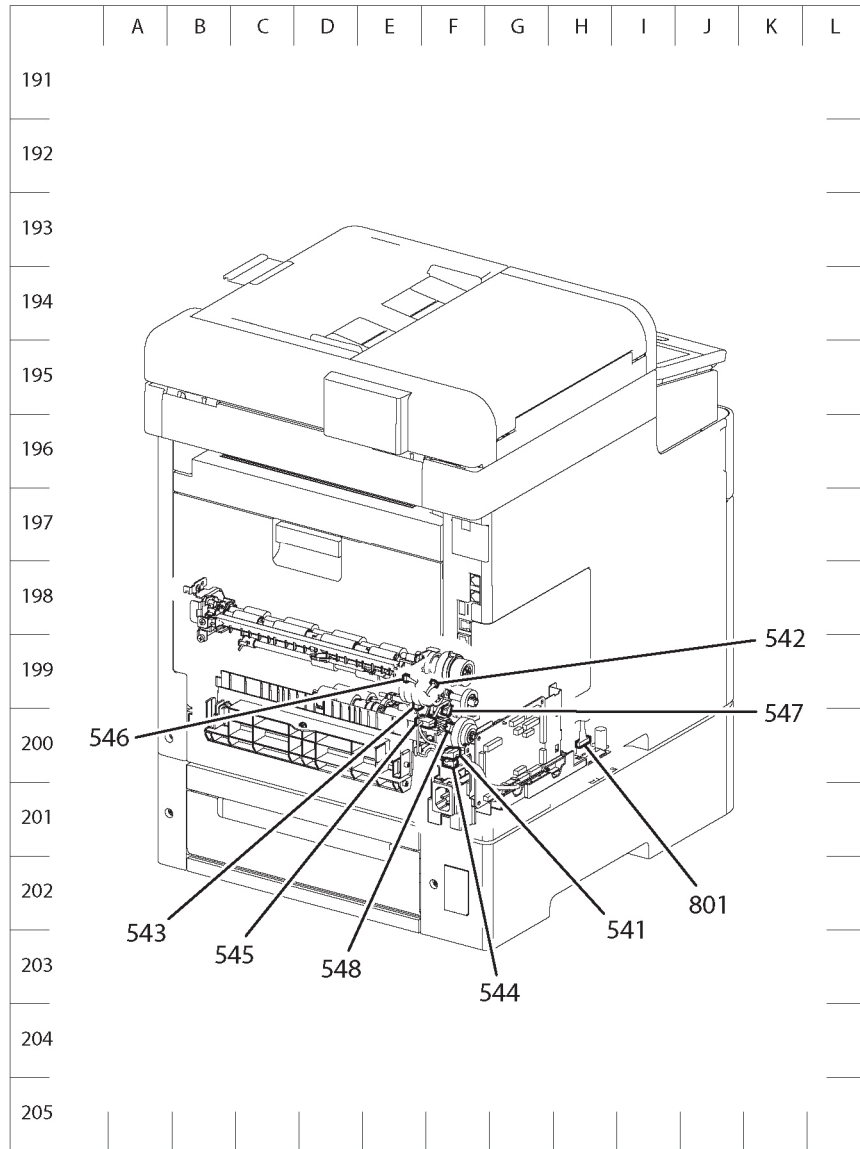
s6510_6515-181

Figure 7 MFP P/J Locator Map 7

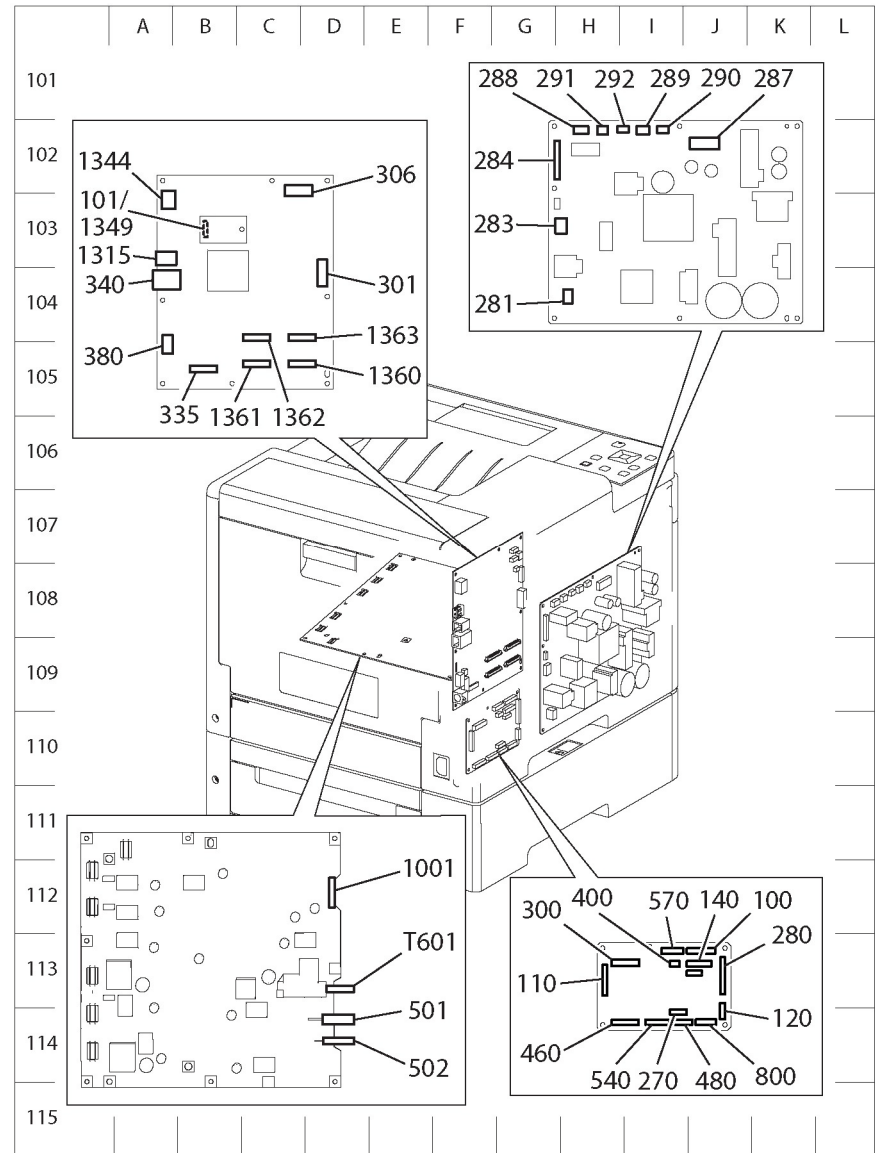
s6510_6515-182b

Figure 1 SFP P/J Locator Map 1

P/J	Map	Coordinates	Connection
1315	Figure 1	A-103	SFP ESS Board and USB 3.0 Device
1344	Figure 1	A-102	SFP ESS Board and Wireless Module
1349	Figure 1	B-103	SFP ESS Board and EMMC Board
1360	Figure 1	C-105	SFP ESS Board and LPH Color (Y) Head Assembly
1361	Figure 1	C-105	SFP ESS Board and LPH Color (M) Head Assembly
1362	Figure 1	C-104	SFP ESS Board and LPH Color (C) Head Assembly
1363	Figure 1	C-105	SFP ESS Board and LPH Color (K) Head Assembly
T601	Figure 1	D-113	HVPS Board and Trans Supply Harness Assembly

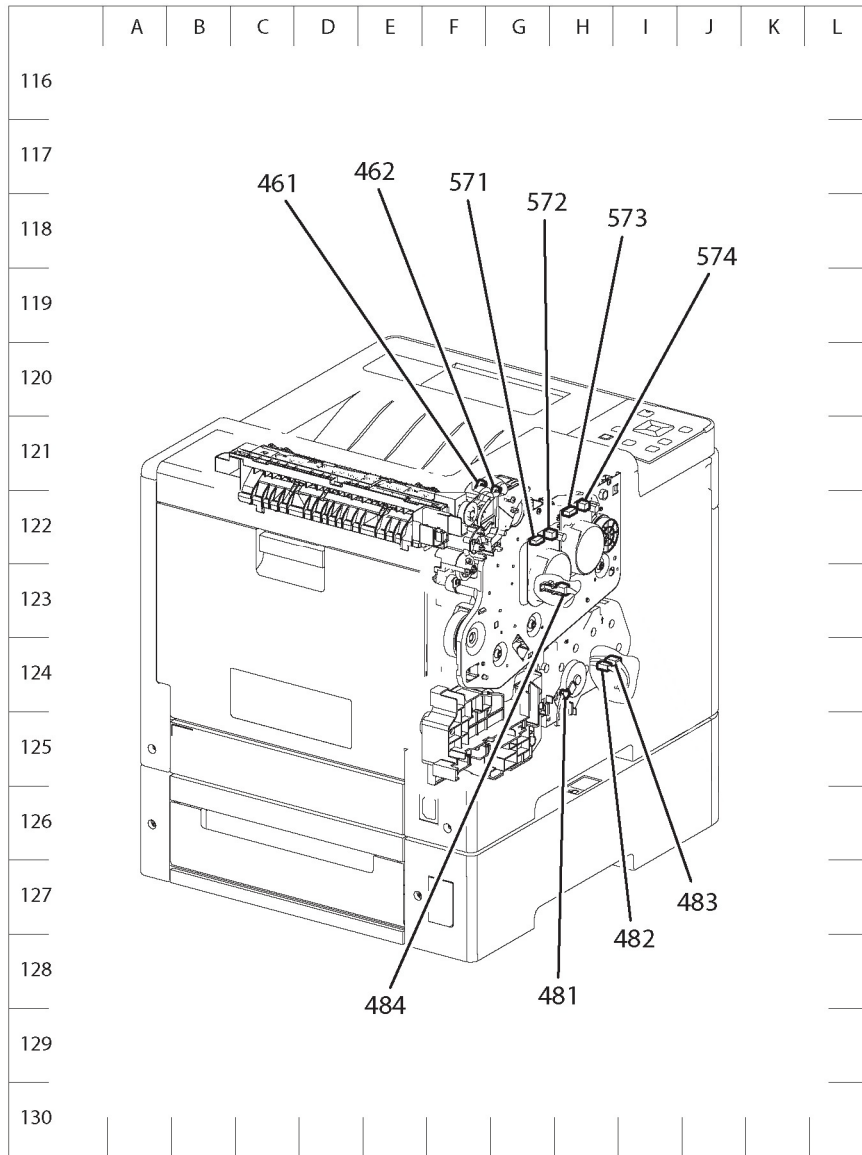
s6510_6515-183b

Figure 2 SFP P/J Locator Map 2

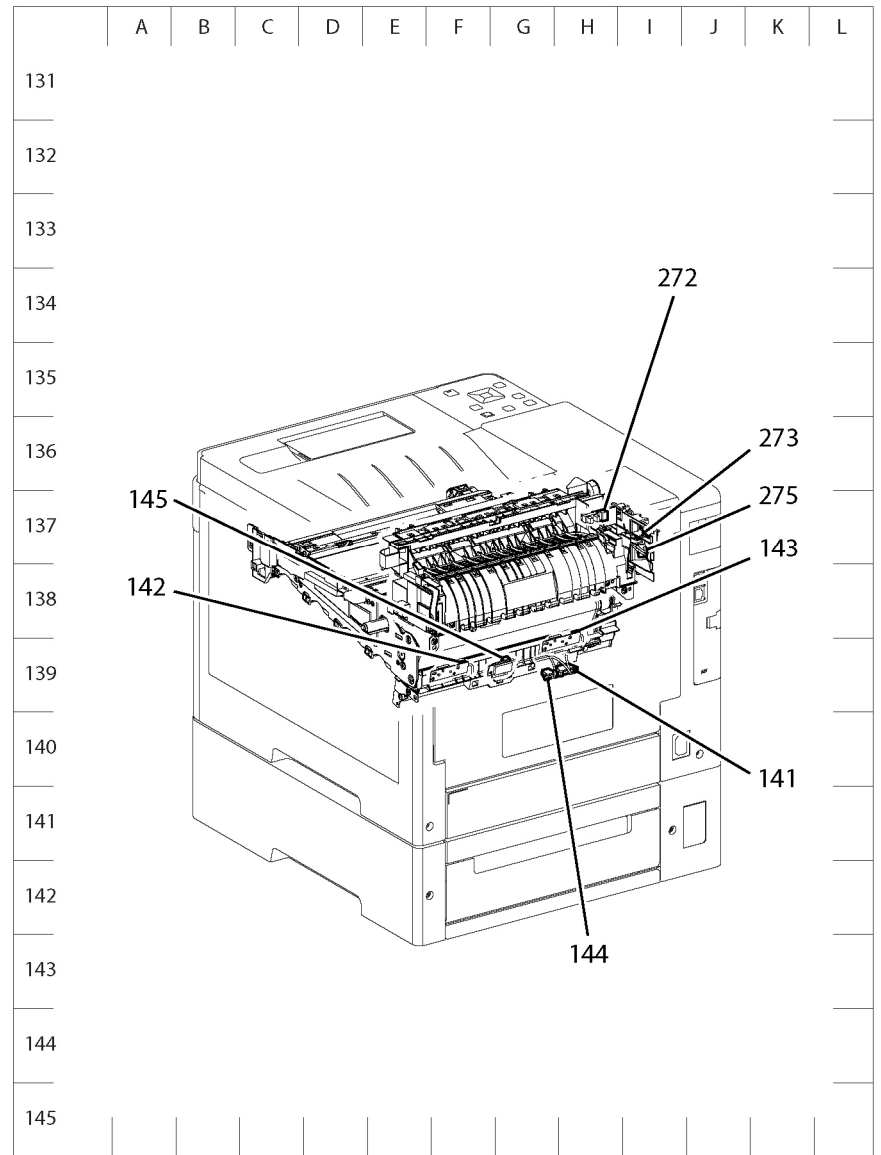
s6510_6515-184

Figure 3 SFP P/J Locator Map 3

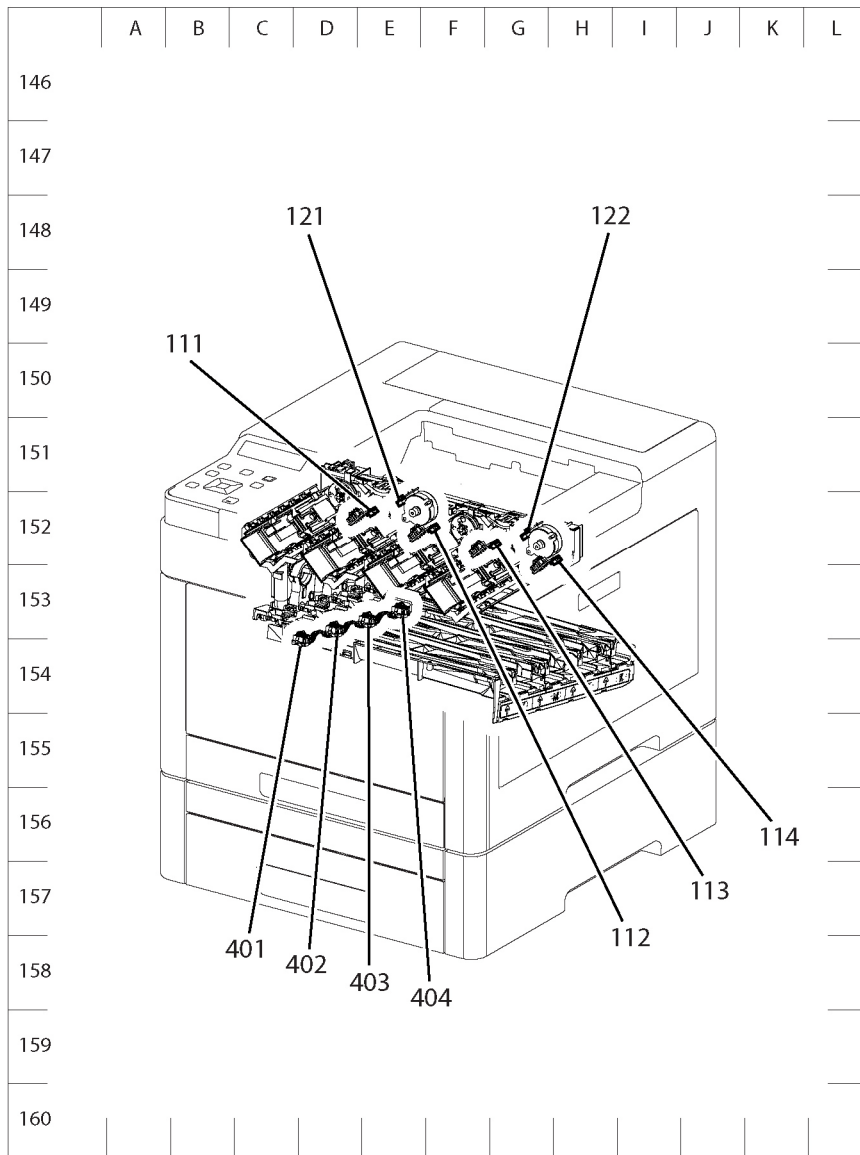
s6510_6515-185

Figure 4 SFP P/J Locator Map 4

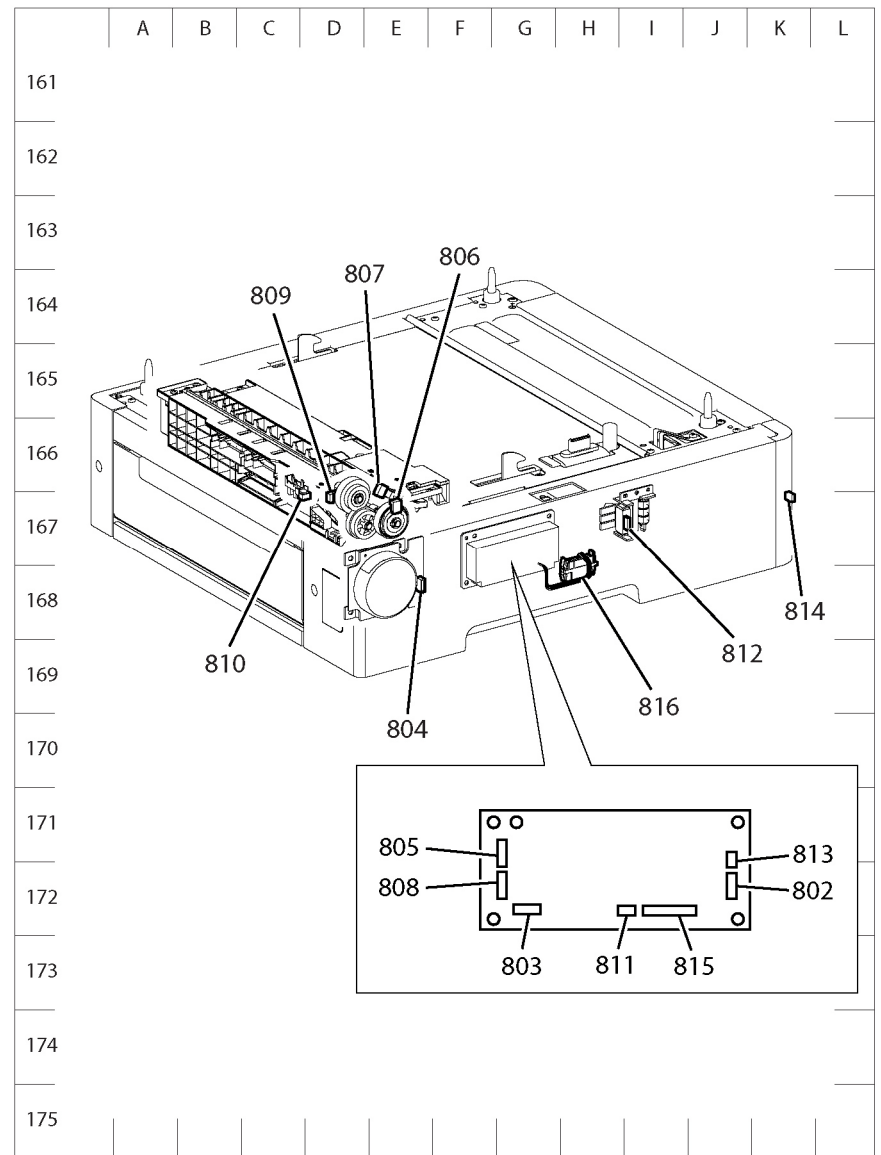
s6510_6515-186

Figure 5 SFP P/J Locator Map 5

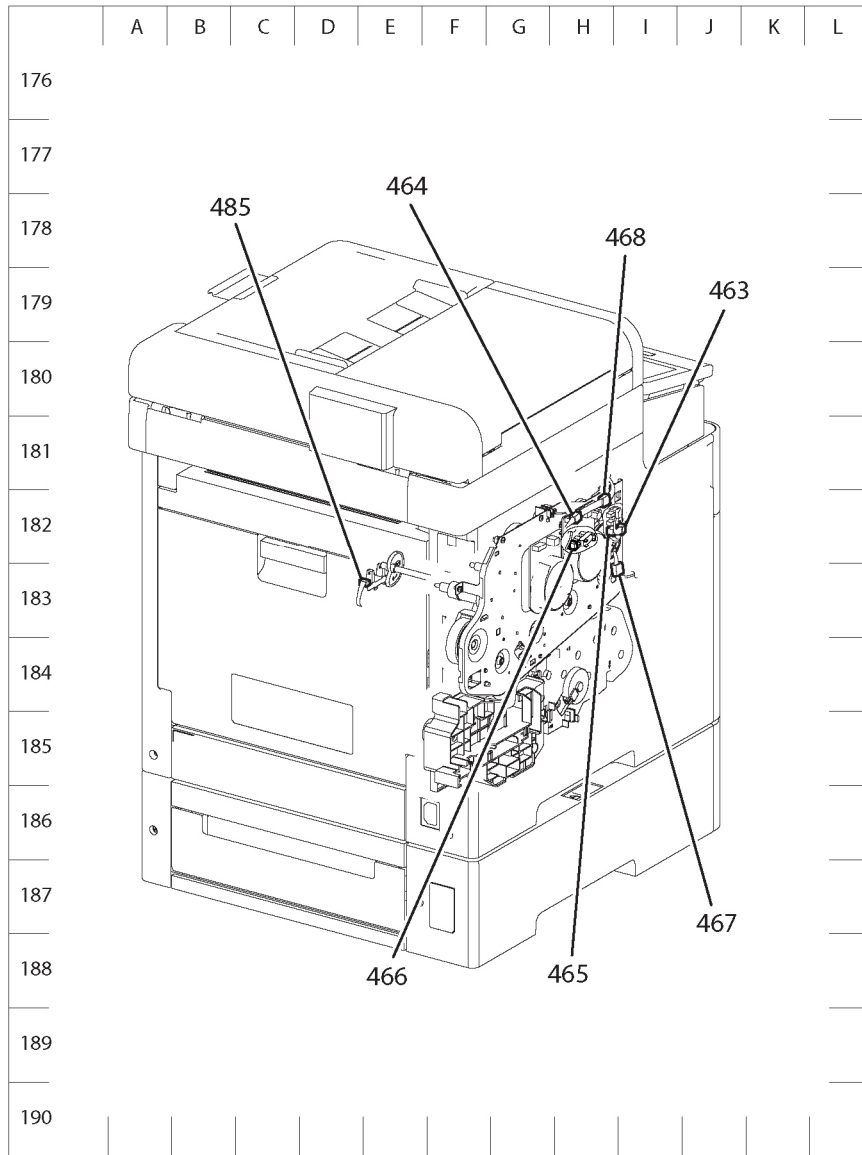
s6510_6515-187

Figure 6 SFP P/J Locator Map 6

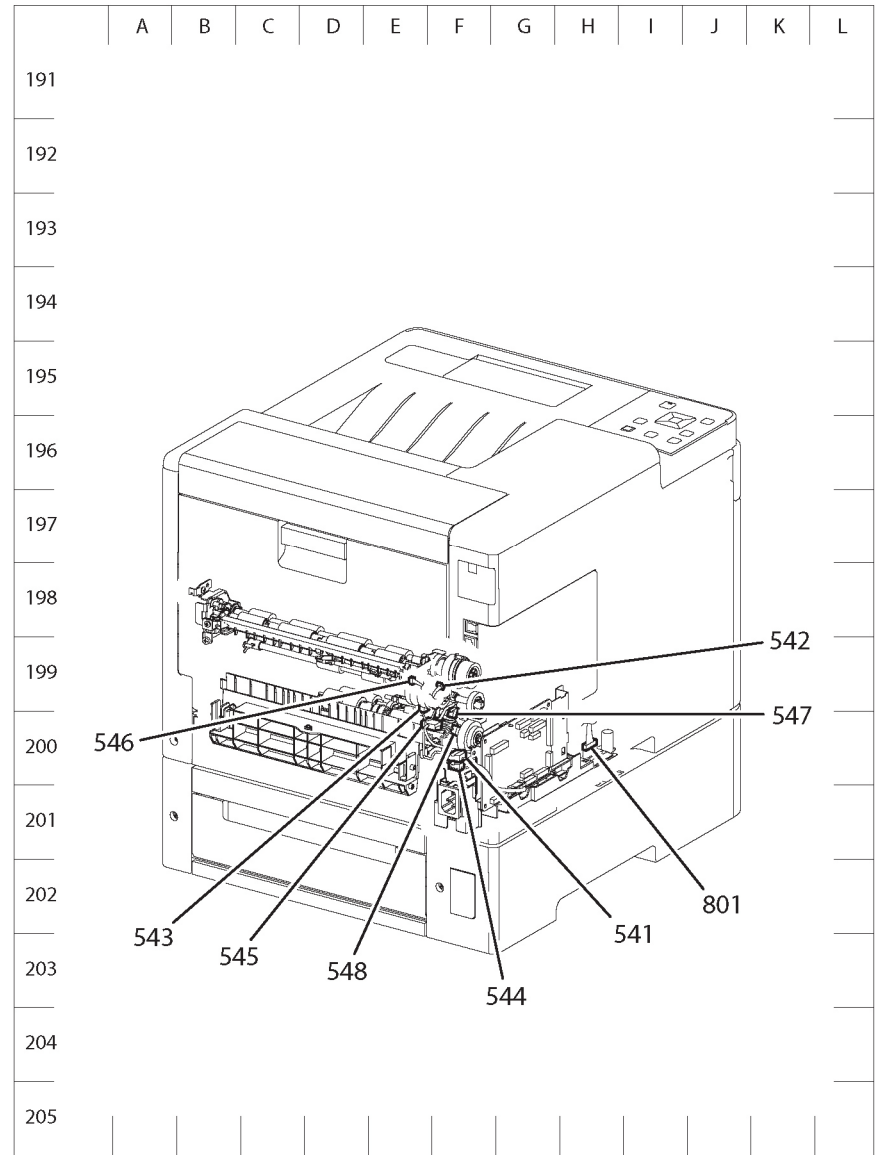
s6510_6515-188

Figure 7 SFP P/J Locator Map 7

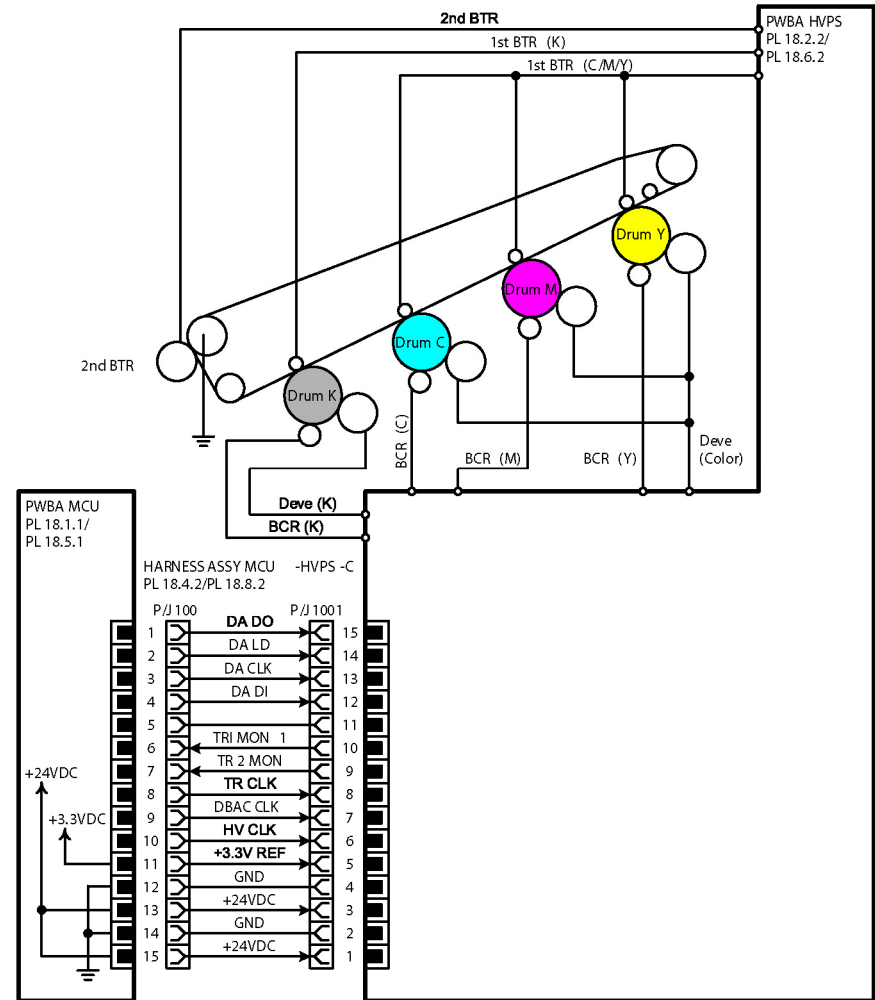
Figure 5 HVPS Wiring Diagram

Table 6 describes the HVPS signal lines.

Signal Line Name	Description
DATA XERO CLOCK XERO	Control signal of the DEVE/XERO CRUM
VL Vdif Vspe	Toner patch density data measured by the R-RAD Sensor and the R-RAD Low Sensor
TEMP SNS	The temperature data in the machine that is measured by Humidity and Temperature Sensor
HUMI SNS	The humidity data in the machine that is measured by the Humidity Sensor

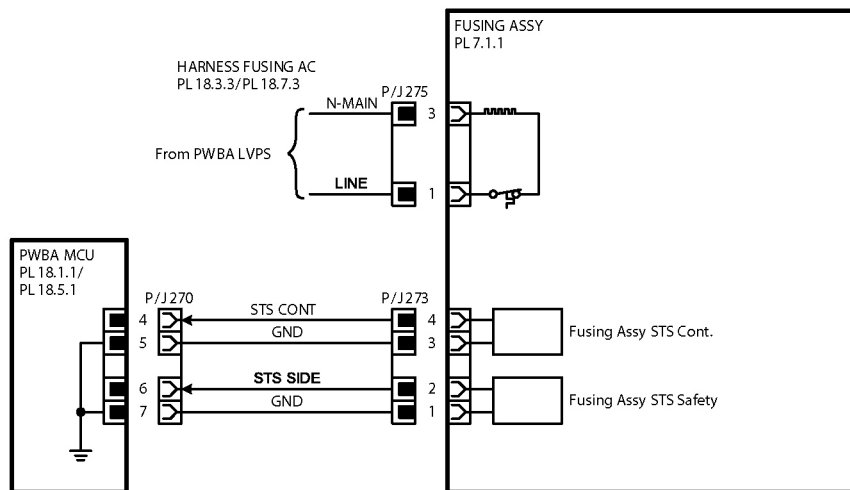
Figure 7 Fuser Wiring Diagram

Signal Line Name	Description
STS CONT	Temperature data measured by Temp. Sensor (Safety) for controlling temperature
STS SIDE	Temperature data measured by Temp. Sensor (Cont) for controlling temperature

Fuser Wiring Diagram

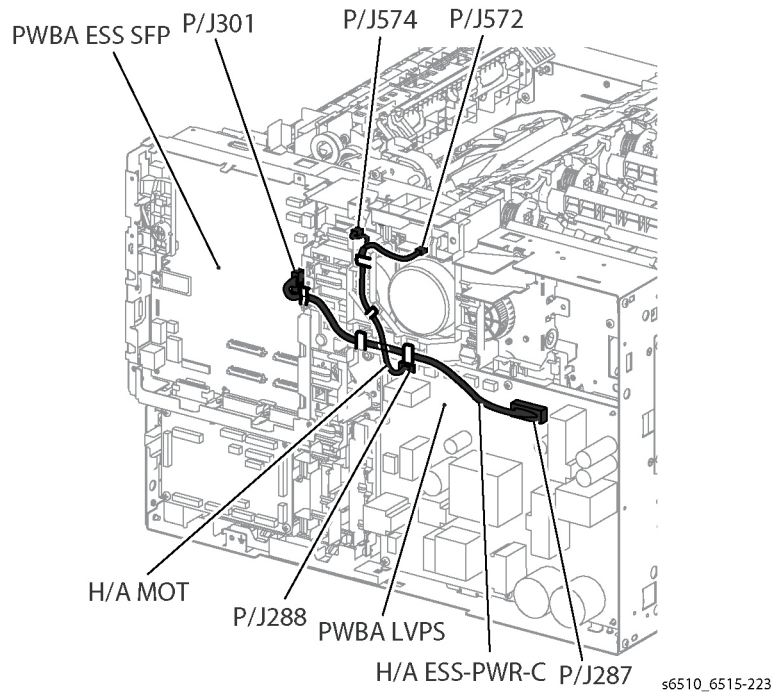
Figure 1 ESS-Power-C, and Motor Harnesses

The following illustrations show factory harness routing paths through the SFP chassis. Refer to Table 1 for a list of available routing diagrams.

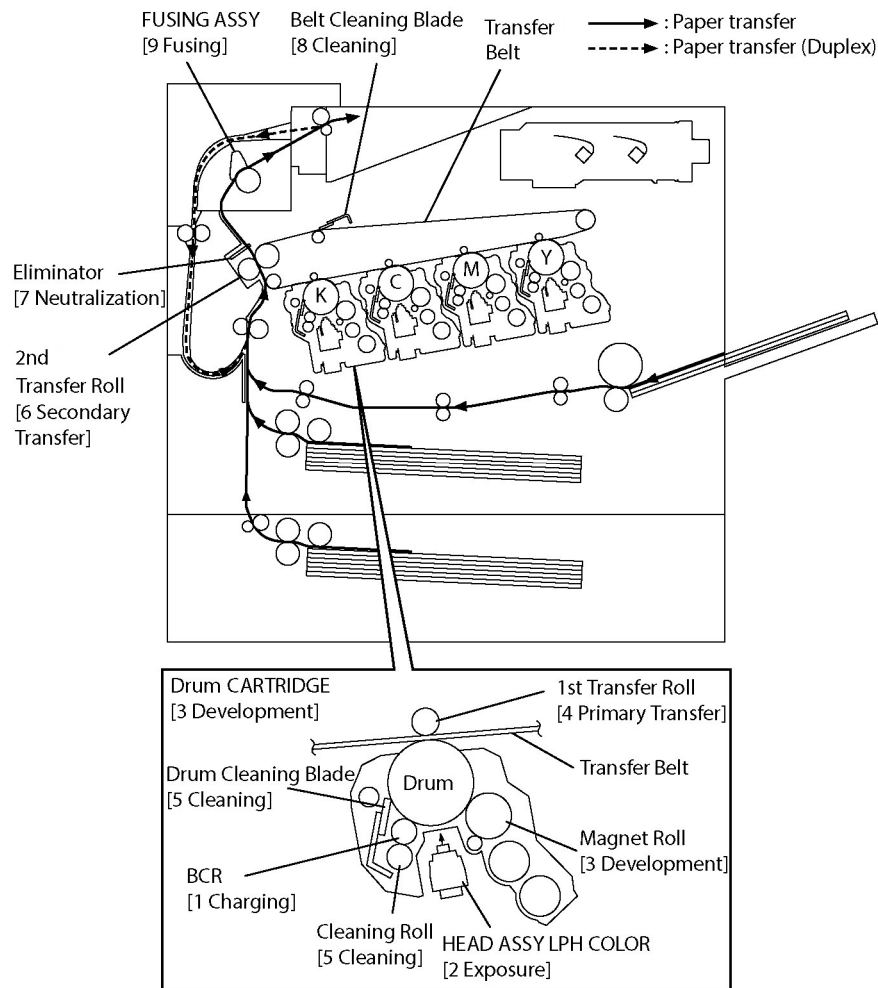
Figure 2 shows the printing process outline.

Figure 2 Printing Process Functions

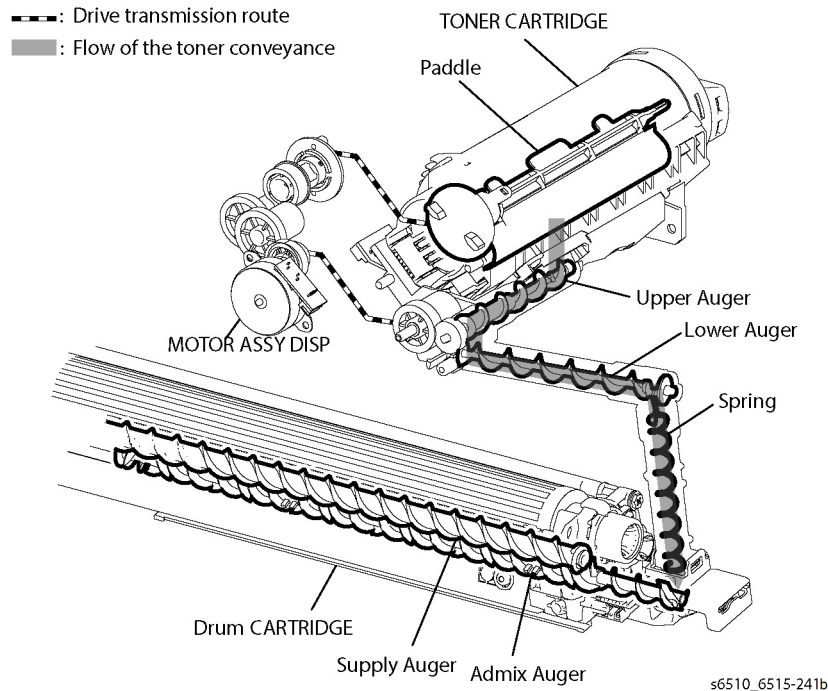
The toner in the TONER CARTRIDGE is fed into the Drum Cartridge by the Upper Auger and the Lower Auger driven by the MOTOR ASSY DISP as shown in Figure 3. The toner supplied from the TONER CARTRIDGE is fed toward the Drum Cartridge by the Upper Auger and the Lower Auger in the DISP ASSY and the paddle in the TONER CARTRIDGE driven by the MOTOR ASSY DISP.

Figure 3 Toner Dispensing During Development

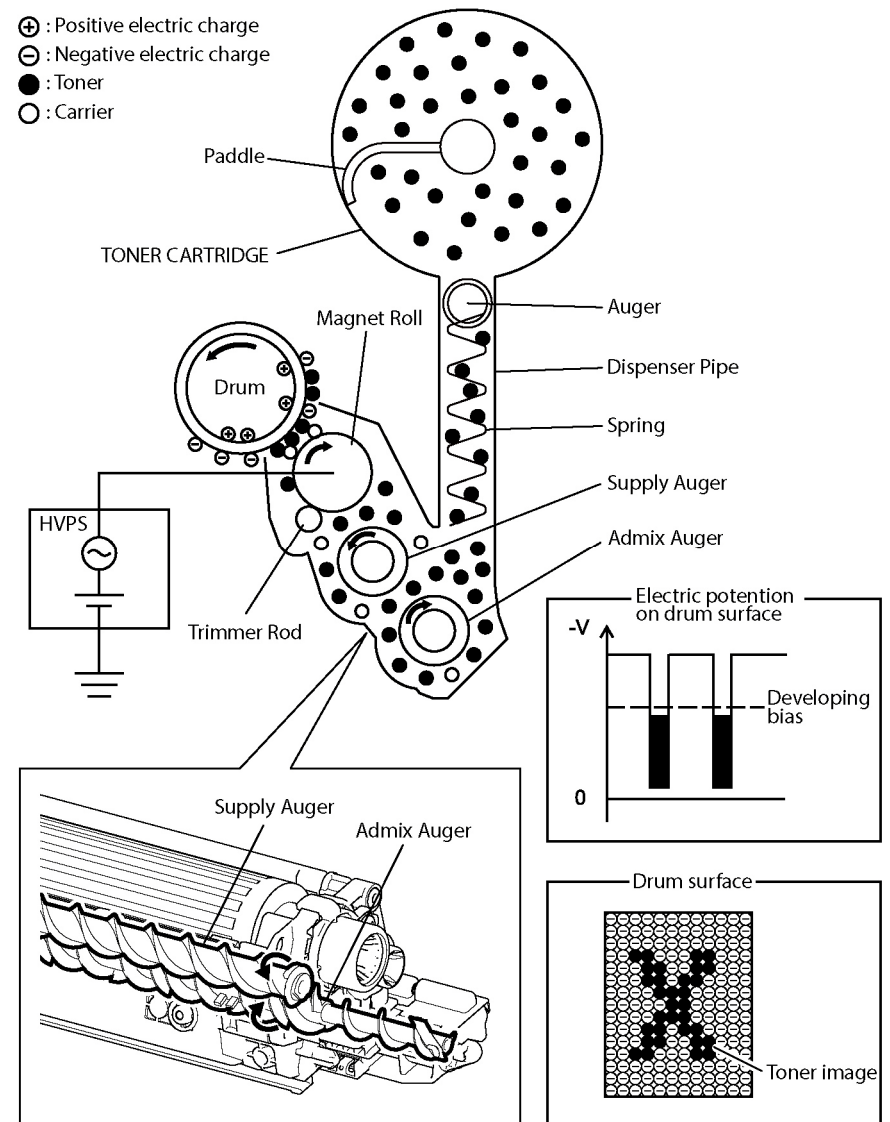
In the developer section, the incoming toner is mixed with the existing developer (toner/carrier mixture) by the Admix Auger and the Supply Auger, and then supplied to the Magnet Roll located near the drum surface as shown in Figure 4. The toner and carrier are charged by friction due to agitation (toner in negative, carrier in positive), and they attract each other electrically. The carrier, due to its magnetic properties, is attracted to the Magnet Roll, and then uniformly leveled by the Trimmer Rod.

The Magnet Roll is covered by a thin semi-conductive sleeve all over the surface. The DB (Developing Bias) voltage is supplied to this semiconductor sleeve from the High Voltage Power Supply (HVPS). The DB voltage is negative DC voltage combined with AC voltage. The DC voltage keeps the Magnet Roll at a constant negative voltage against the photoreceptor layer of the drum. Therefore, at the area where the negative electric charge on the drum surface does not decrease, the potential is lower than that of the Magnet Roll, while the potential is higher than that of the Magnet Roll at the area where the negative charge on the drum surface decreases. The AC voltage shakes the developer on the surface of the Magnet Roll so that the toner easily flies to the drum. Thus, only the portions of the drum surface where the negative charge has decreased below that of the Magnet Roll (electrostatic latent image) attract the toner to form an image on the drum. Once the toner is deposited on the drum, the potential and the toner-attracting force of the corresponding portion decreases because the increase of negative charge lowers the potential at that portion.

Figure 4 Development Process

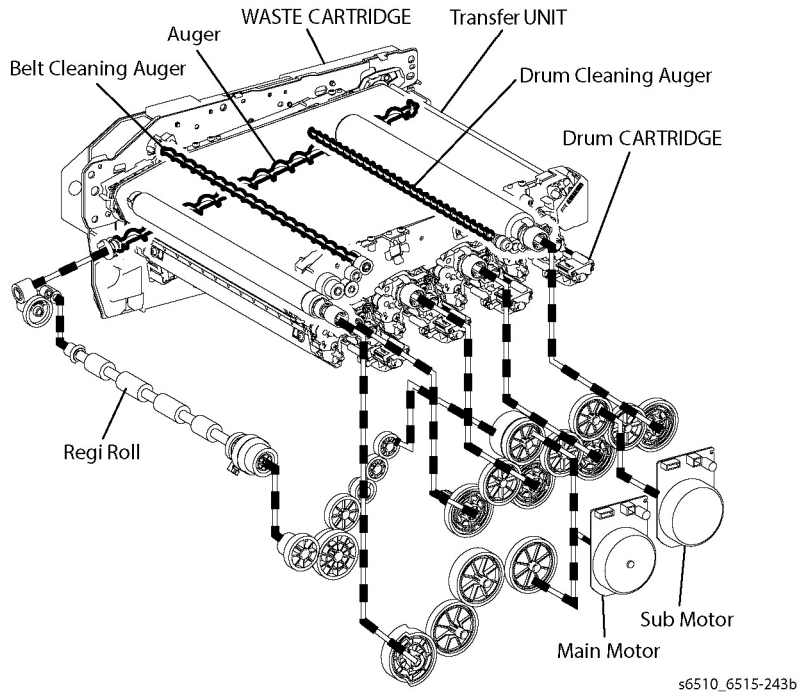
The excess toner fed to the Waste Cartridge is collected into the cartridge by the Waste Auger in the Waste Cartridge.

The Waste Auger in the Waste Cartridge is driven by the Main Motor via the Regi Roll.

Figure 5 Waste Toner Collection

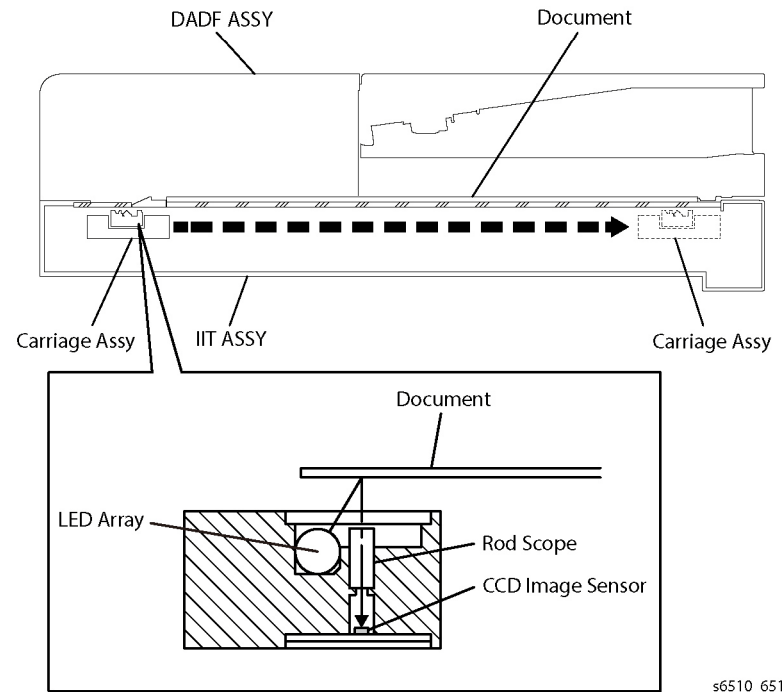
The SCANNER ASSY, shown in Figure 1, consists of the Image Input Terminal (IIT) and the Auto Document Feeder (ADF). Document scanning is performed by the Carriage Assy in the Image Input Terminal.

The Carriage Assy consists of components such as the CCD Image Sensor for converting image to data, the LED Array for illuminating the original, and the Rod Scope for converting the original image to a full-size erect image.

Figure 1 Scanning at Platen (IIT) Assembly

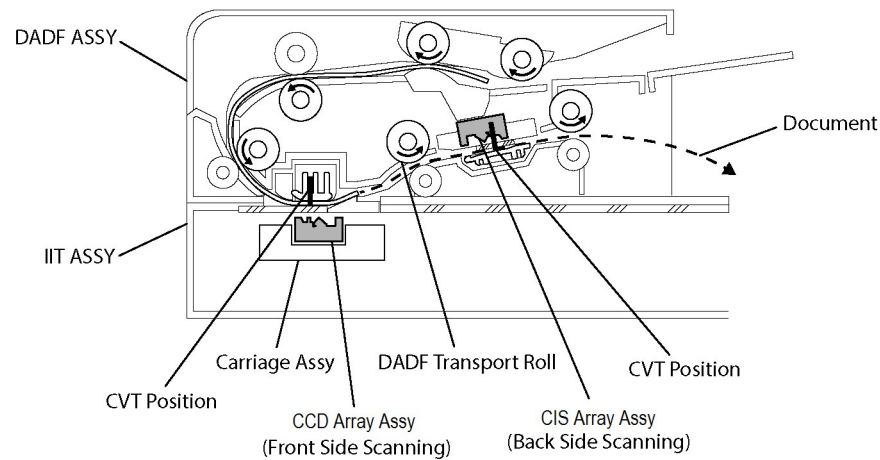
This DADF, shown in Figure 2, has a different system from the conventional document feeder, being capable of scanning both the front and back sides of the document during the one-pass conveyance. The CCD Array Assy on the IIT ASSY reads the front side of the document, and the CIS Array Assy on the DADF ASSY reads the back side of the document. These two scanning parts are arranged so as to interpose the paper path from both sides, and this allows both sides of the document to be scanned without rotation.

When the document being fed by the torque from the DADF Motor at the speed corresponding to the set magnification passes the Scanner Home Position (CVT: Constant Velocity Transport) of the Carriage Assy in the IIT ASSY, allowing the reflected image to be read by the CCD Image Sensor.

Figure 2 Scanning at DADF Assembly

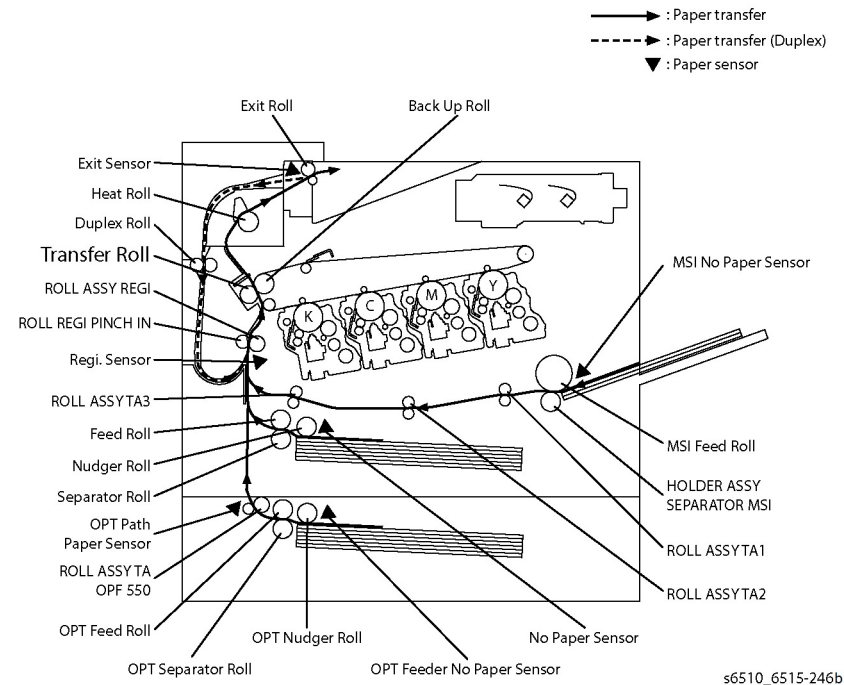
Figure 1 shows the paper feed layout when the tray module is installed, and the components relevant to paper feed.

Figure 1 Paper Path Layout

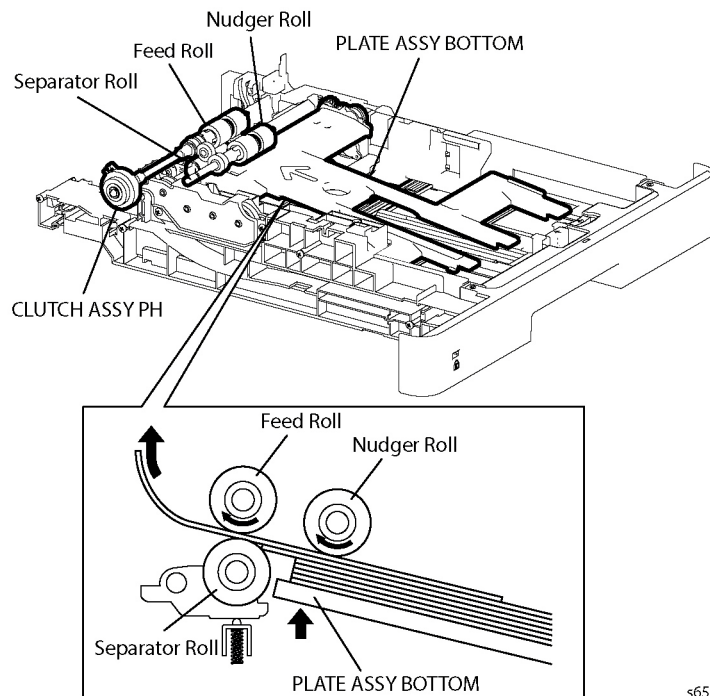
- The Nudger Roll and the Feed Roll are rotated by the Main Motor via the CLUTCH ASSY PH.
- The Separator Roll, pressed from underneath by the spring pressure and forced against the Feed Roll, fans a sheet by the rotation friction.
- When the sheet is lapped over, the break force of the torque limiter combined with the Separator Roll separates and feeds only the top sheet.

- The PLATE ASSY BOTTOM is the mechanism driven with the gear located on the side of the paper cassette.
- Unless the interlock gear is unlocked, the PLATE ASSY BOTTOM keeps the state that it is not lowered or elevated from the arbitrary position. The sheet is fed at this position.
- As paper is fed and the stack of paper decreases by several sheets, the Nudger Roll lowers down and the lever unlocks the gear, which elevates the PLATE ASSY BOTTOM.

Figure 2 Feeding from Paper Cassette

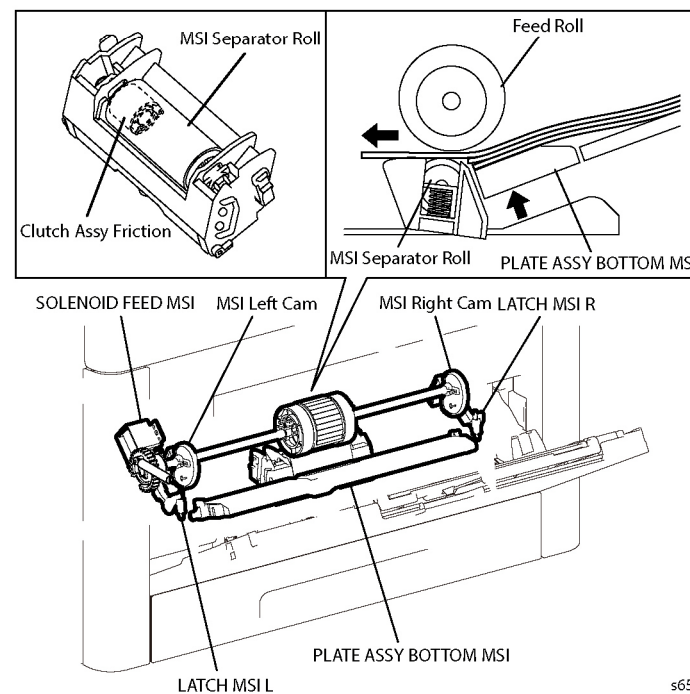
Normally, when only one sheet is fed, both the MSI Feed Roll and MSI Separator Roll rotate to allow the sheet to pass. However, when two sheets are fed concurrently, only the MSI Feed Roll rotates and the MSI Separator Roll is locked. This allows the upper sheet to pass by being separated from the lower sheet that is stopped by the friction with the MSI Separator Roll at rest.

The MSI Separator Roll is pushed toward the MSI Feed Roll by spring pressure, and controlled by the torque limiter (Clutch Assy Friction) with which it is coupled.

Figure 3 Feeding from the Bypass Tray

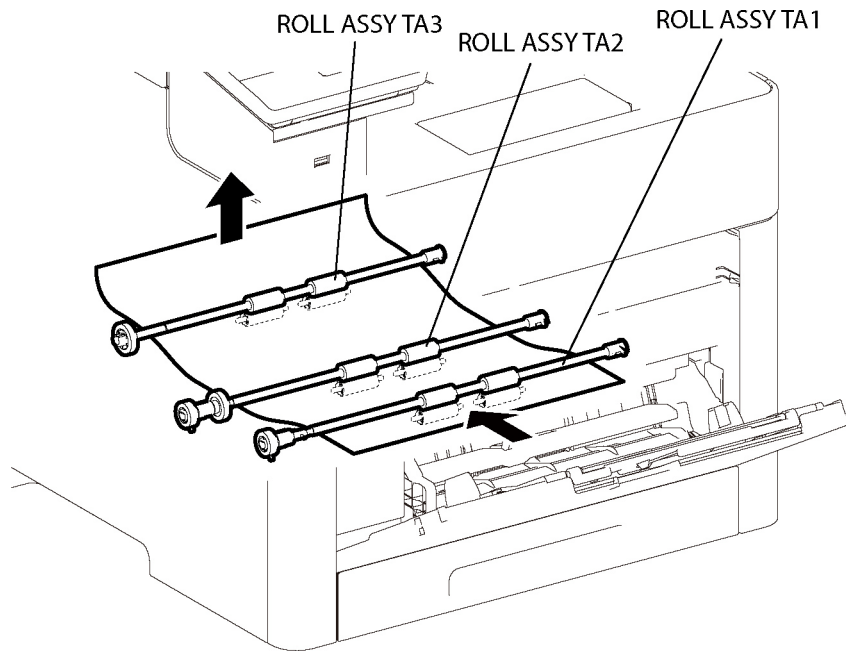
The sheet fed from the MSI is fed to the registration section by the ROLL ASSY TA1, ROLL ASSY TA2, and ROLL ASSY TA3 driven by the Main Motor. See Figure 4.

Figure 4 Feeding Through the Takeaway Rolls

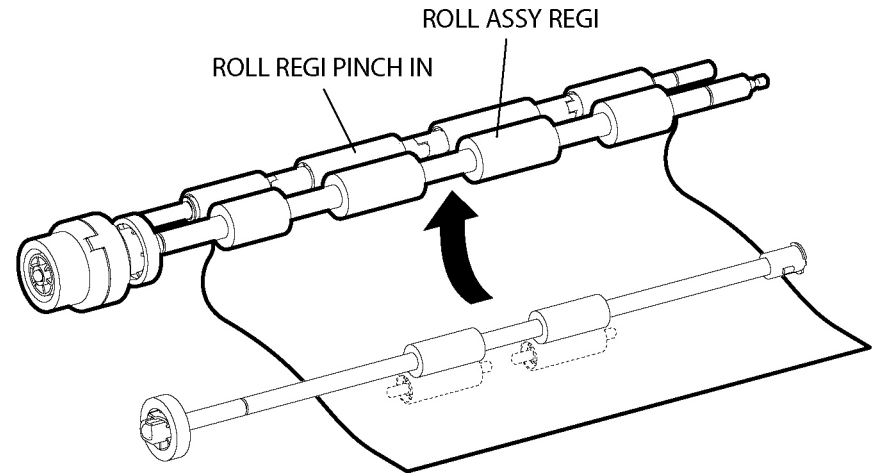
The sheet fed from the paper cassette is passed through the chute directly and fed to the registration section. See Figure 5.

Figure 5 Feeding to the Registration Section

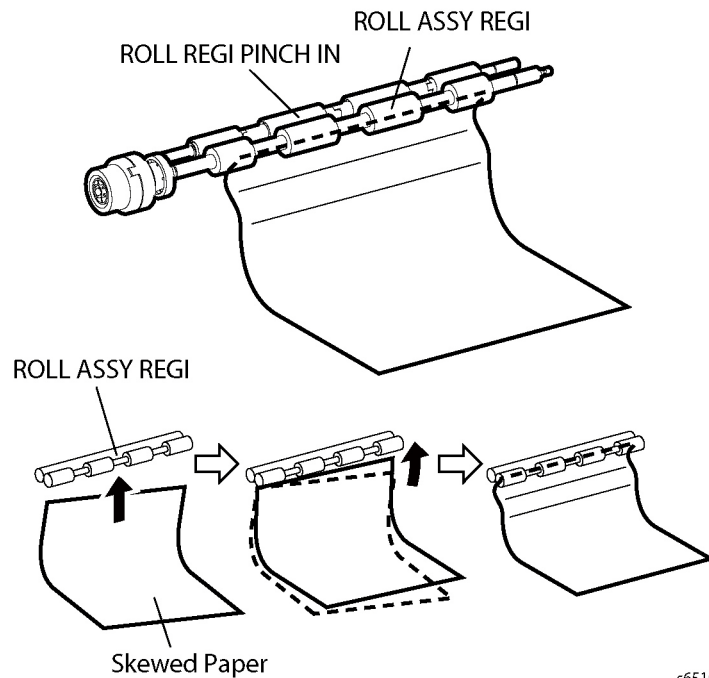
By thrusting the edge of the sheet fed out of the MSI or Tray against the locked ROLL ASSY REGI, the sheet's lead edge position is corrected. See Figure 6.

Figure 6 Sheet Leading Edge Position Correction

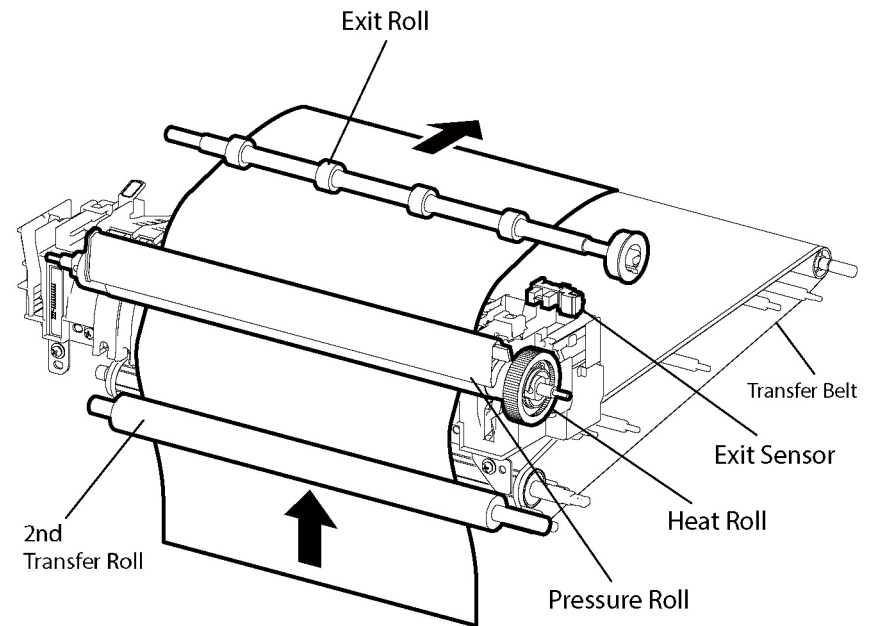
On the sheet passed through the registration section, the toner image on the Transfer Belt is transferred by the Transfer Belt and the 2nd Transfer Roller rotated by the Main Motor drive. Then, the sheet is fed to the exit section while its toner image is being fused by the Heat Roll rotated by the Main Motor. See Figure 7. Also, the Main Motor drive is transmitted to the Exit Clutch, and the Exit Roll is rotated in the sheet exit direction. The printed sheet is ejected from the printer. The Exit Sensor detects when the sheet completely exits the printer.

Figure 7 Feeding Through the Transfer/Fusing/Exit
