Phaser® 6510, WorkCentre® 6515 Service Manual

Xerox Phaser 6510 Color Printer/WorkCentre 6515 Color Multifunction Printer

Phaser 6510 Color Printer/WorkCentre 6515 Color Multifunction Printer Service Manual

705P01382

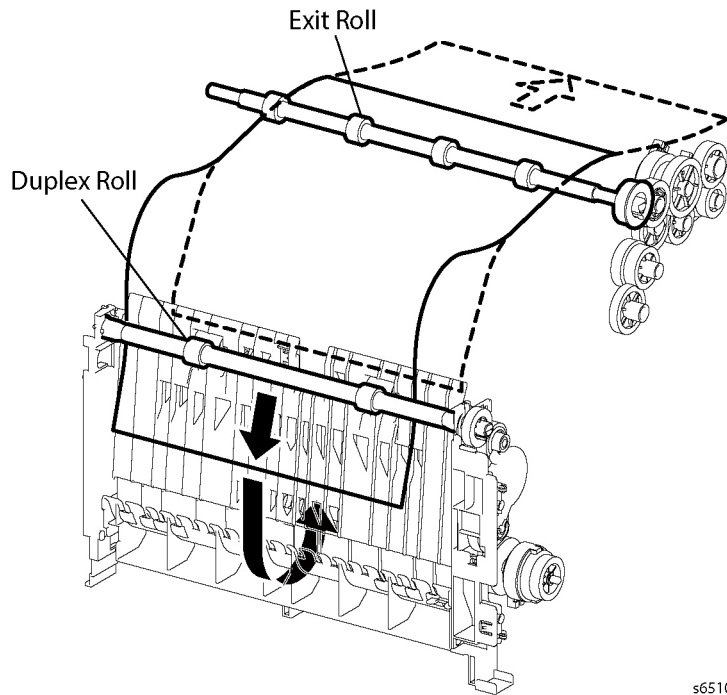
After the sheet is passed through the Heat Roll and side 1 printing is completed, the rotation direction of the Exit Roll is changed to the duplex feed direction at the proper timing, and the sheet is nipped in the Duplex Assembly. See Figure 8. When the Main Motor drive is transferred to the Exit Clutch 2, the Exit Roll is rotated in the duplex direction. Also, the Duplex Roll is rotated by the Main Motor drive, and the sheet is fed to the registration position.

Figure 8 Feeding Through the Duplexer

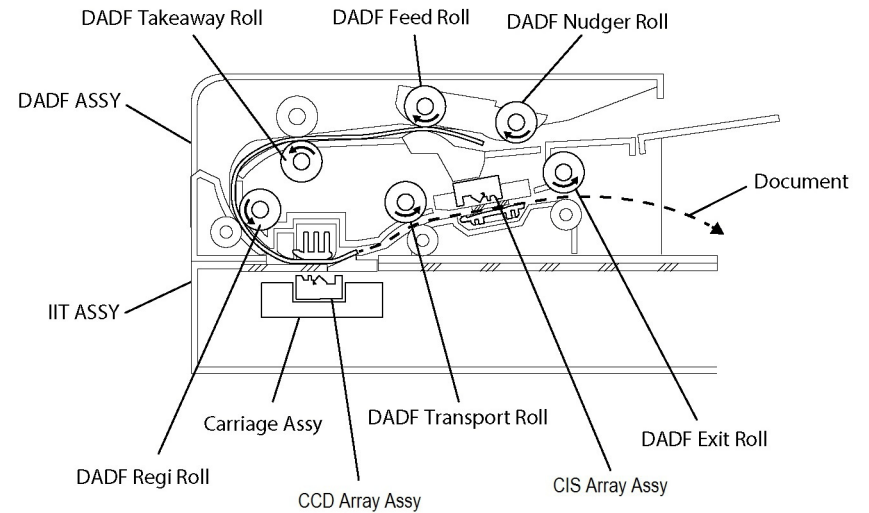
Inside the DADF, the sheet is fed by the DADF Takeaway Roll rotated by the DADF Motor, aligned by the DADF Regi Roll rotated by the DADF Motor, and fed to the Scanner Home (CVT: Constant Velocity Transport) Position in the Carriage Assy, and is scanned (Simplex). Then, the sheet is fed by the DADF Transport Roll rotated by the DADF Motor to the CVT position, and is scanned (Duplex).

After being scanned, the sheet is ejected by the DADF Exit Roll rotated by the DADF Motor to the DADF's Document Output Tray.

Figure 9 Feeding Through the DADF

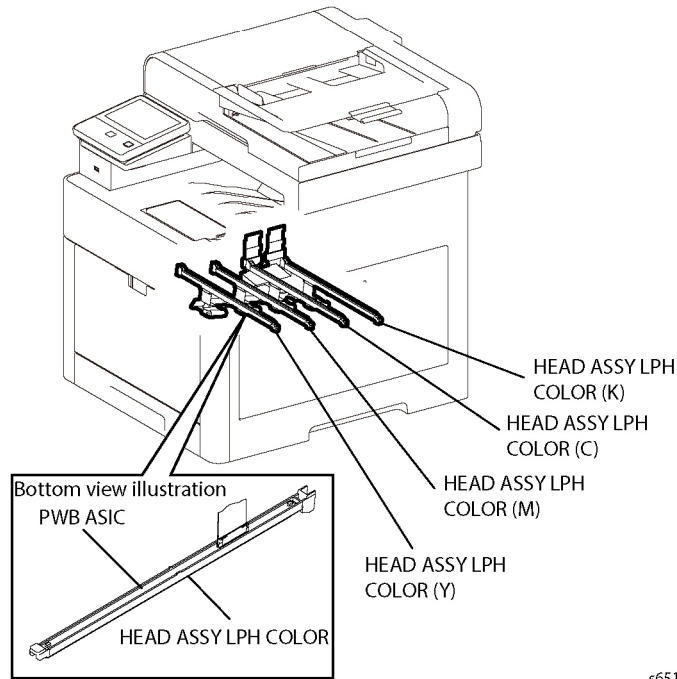
Figure 1 shows the LPH assemblies.

Figure 1 LPH Function

An exposure device for creating an electrostatic latent image on the drum surface. One unit is provided for each color: yellow, magenta, cyan, and black.

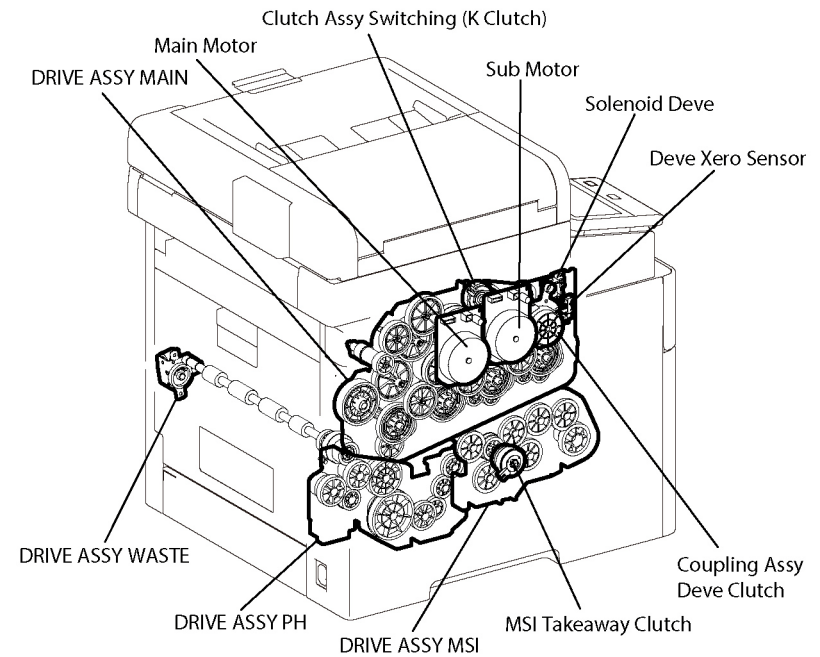
Figure 2 shows the drive assemblies.

Figure 2 Drive Function

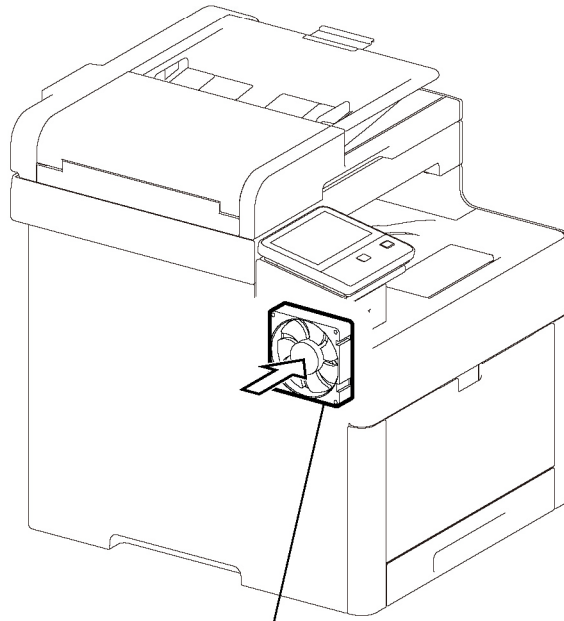
Figure 3 shows the Main Fan.

FAN MAIN

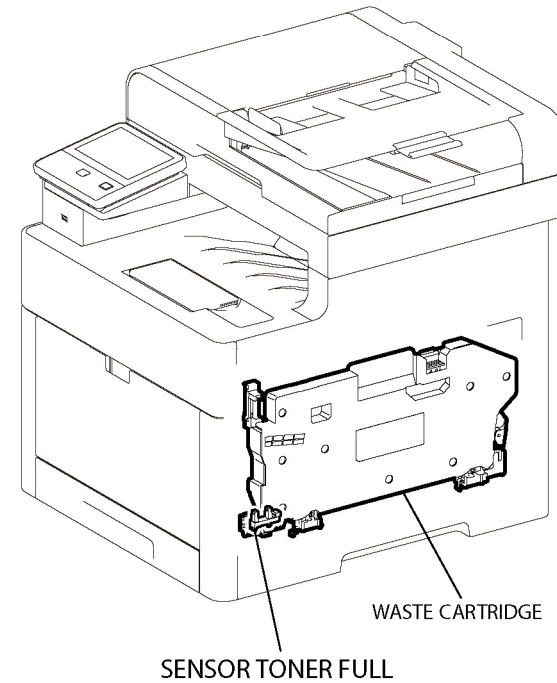
Figure 4 shows the Waste Cartridge.

WASTE CARTRIDGE

SENSOR TONER FULL

Stores the waste toner conveyed from the Transfer Belt and the Drum Cartridge (Y/M/C/K) via the Belt Cleaning Auger and the Drum Cleaning Auger.

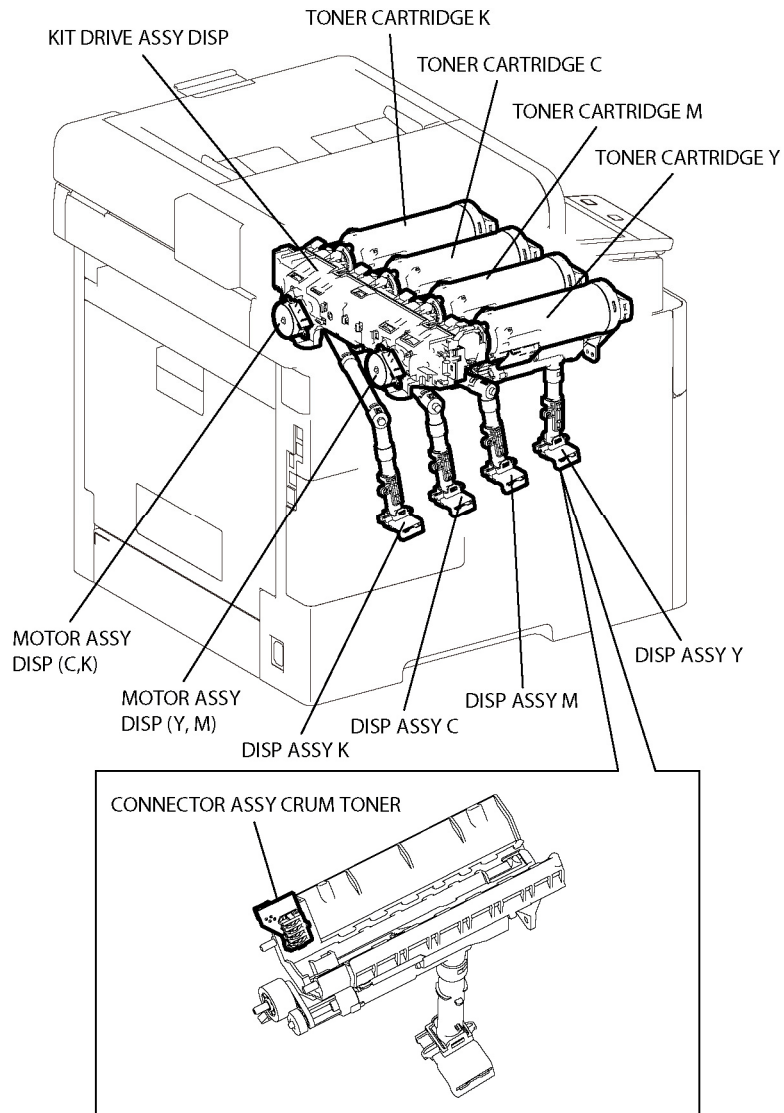
Figure 5 Toner Dispensing Function

- CONNECTOR ASSY CRUM TONER
Detects whether the TONER CARTRIDGE being connected is a regular part.

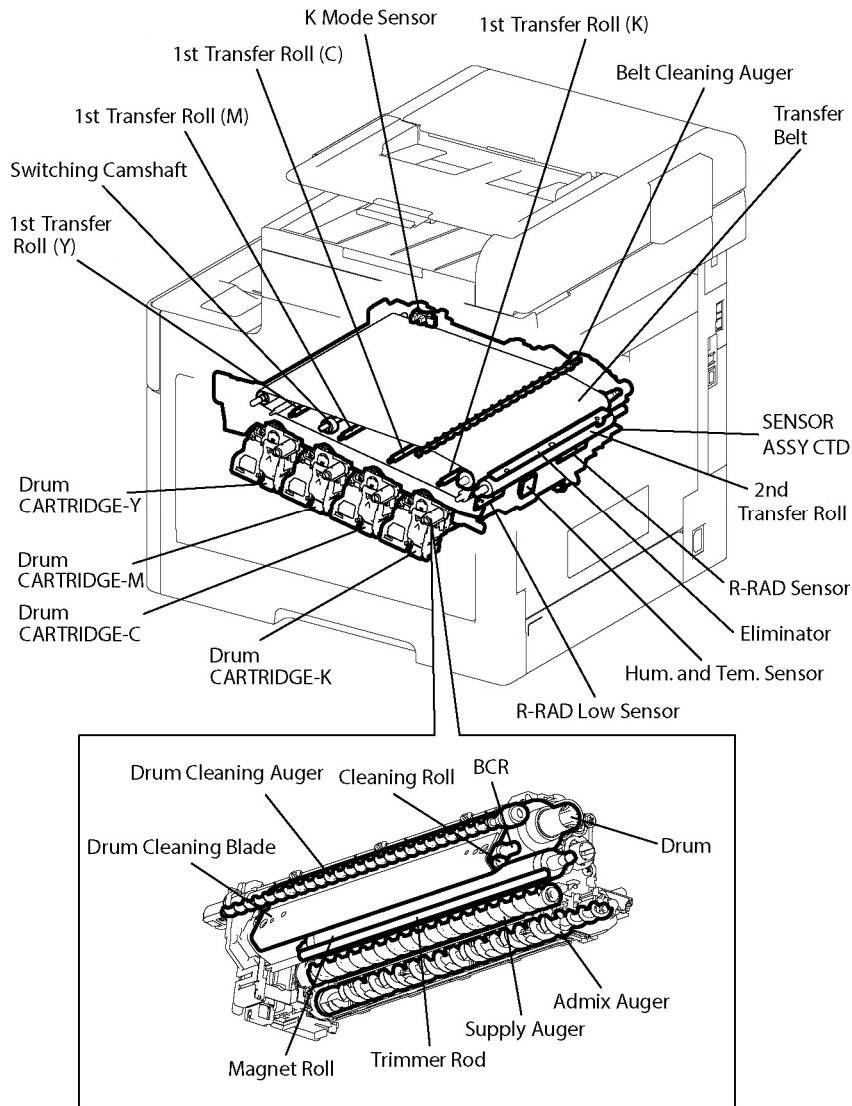
Figure 6 Xerographics Function

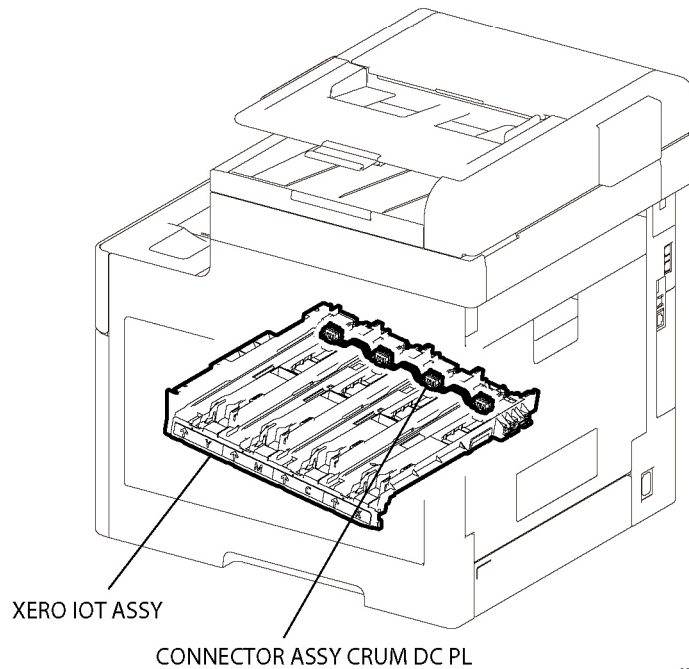
The 2nd Transfer Roller Assy mainly consists of the following components:

- 2nd Transfer Roller
Contacts with the reverse side of the toner transfer face on the sheet, and transfers the toner image formed in the Transfer Belt to the sheet.
- Eliminator
Neutralizes the sheet.

Figure 7 Xerographics Transfer Function

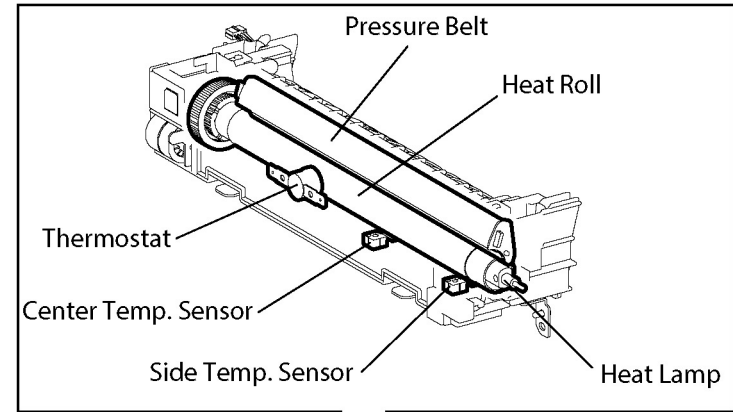
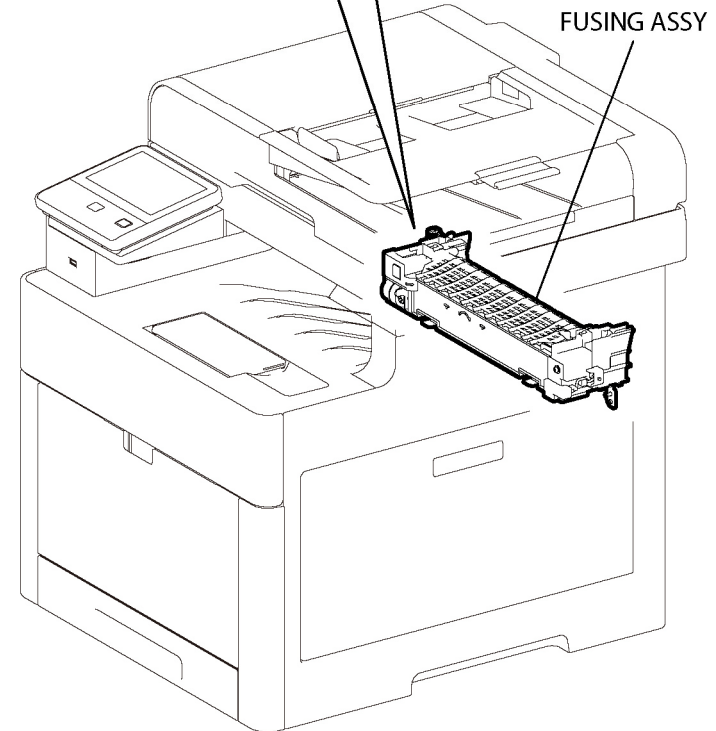
Figure 8 Fuser Function

- Heat Roll
A metal roller, with a surface for transferring heat to fuse toner on a sheet covered by the tube.
- Pressure Belt
A belt contained the pressurization system inside. Combined with the Heat Roll, impresses toner on the sheet.
- Heater Lamp
A heating element sealed inside the Heat Roll.
- Center Temp. Sensor
A thermistor that reacts corresponding to temperature changes, located in the Heat Roll. The sensor detects the Heat Roll's surface temperature, preventing abnormally high temperature.
- Side Temp. Sensor
A thermistor that reacts corresponding to temperature changes, located in the Heat Roll. The sensor detects the Heat Roll's surface temperature, preventing abnormally high temperature.
- Thermostat
Located in series with the Heater Lamp's power source. A secondary device to prevent excessive temperature in the Heat Roll if the Temp. Sensors fail.

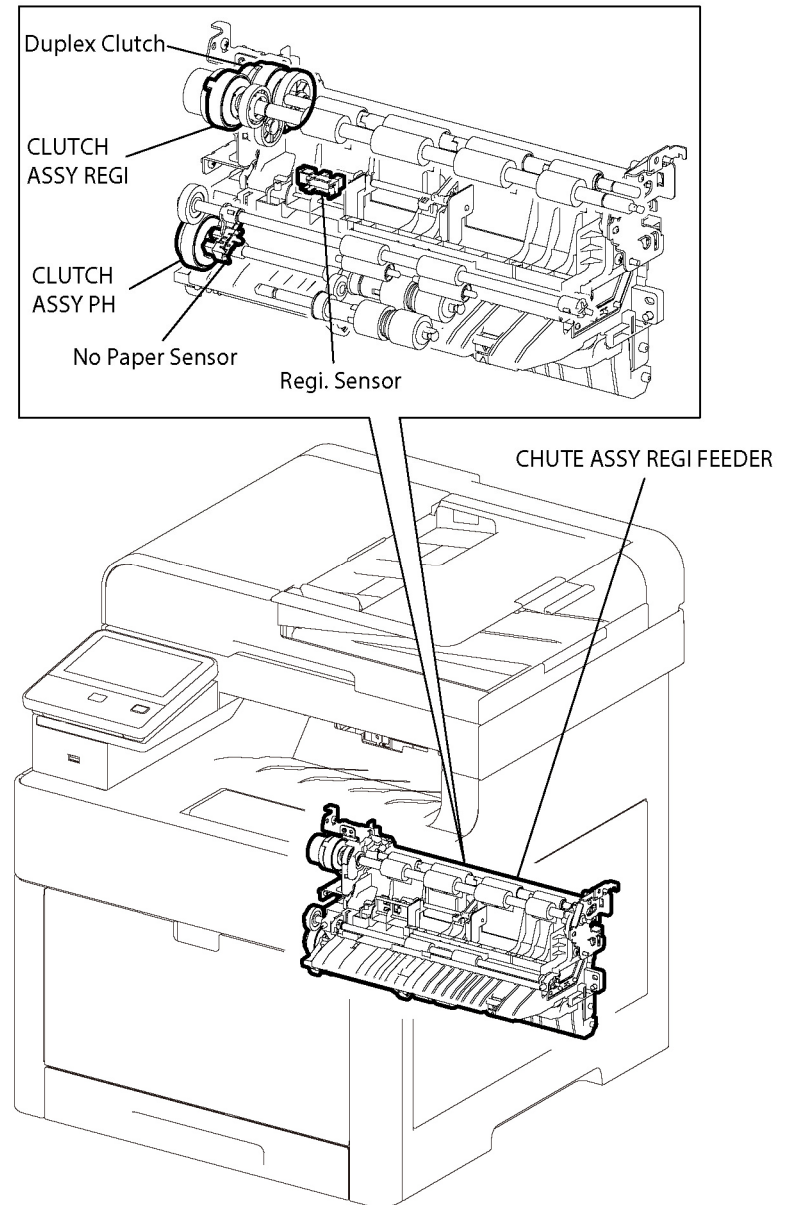
Figure 9 Paper Transport Function

Transfers the Main Motor drive to the Duplex Roll inside the Duplex Assembly.

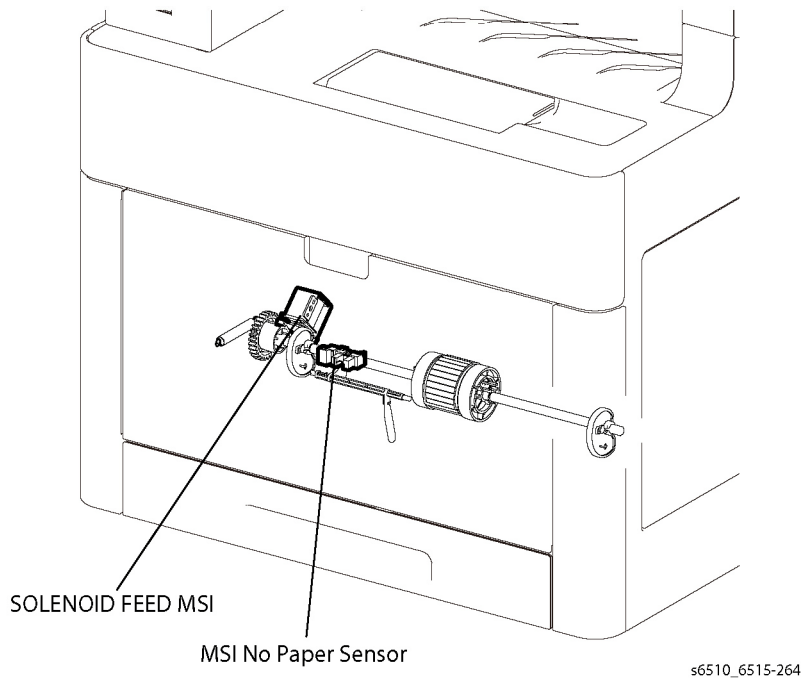
Figure 10 Bypass Function

Transfers the Main Motor drive to the MSI Feed Roll.

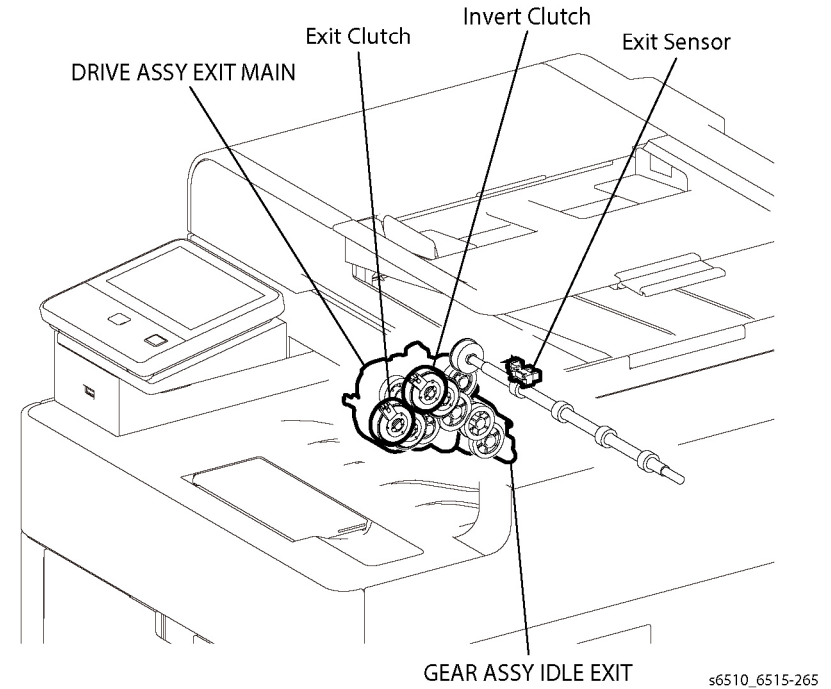
Figure 11 Exit Function

Contains the gears that transmit the Main Motor drive to the gears in the DRIVE ASSY EXIT MAIN.

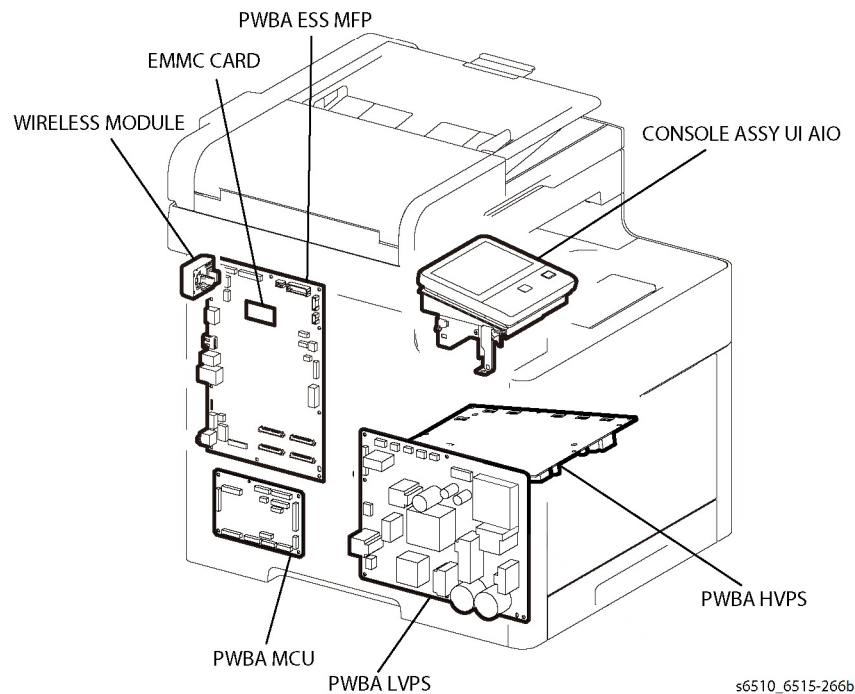
Figure 12 MFP Electrical Function

Non-volatile memory that stores the machine information.

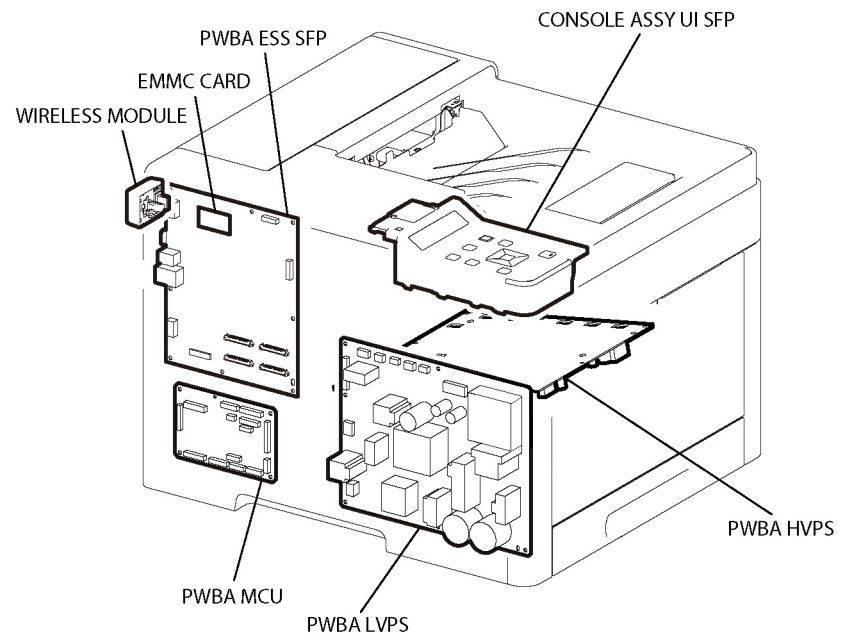
Figure 13 SFP Electrical Function

Non-volatile memory that stores the machine information.

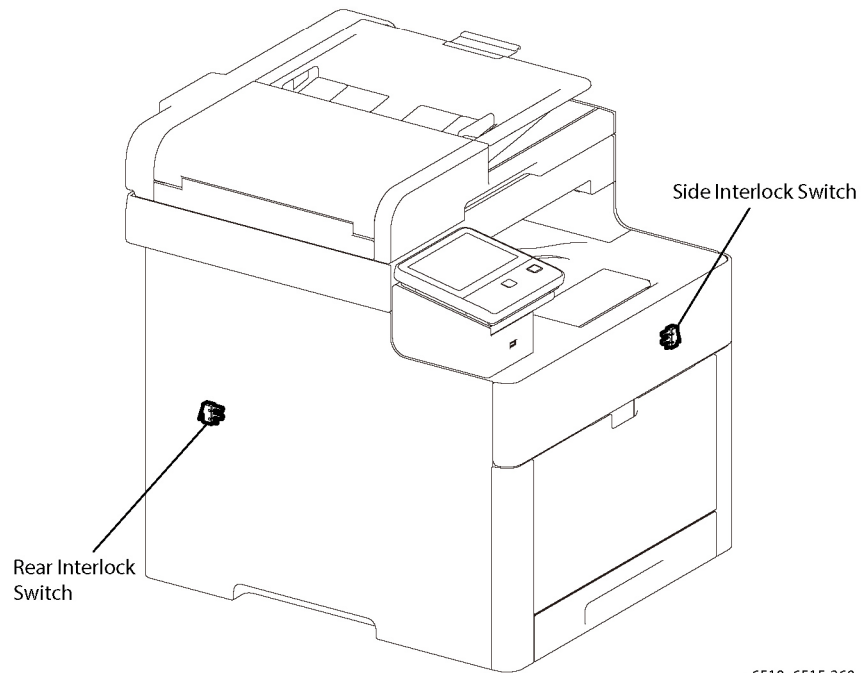
Figure 14 Interlock Function

Detects the opening/closing of the side cover.

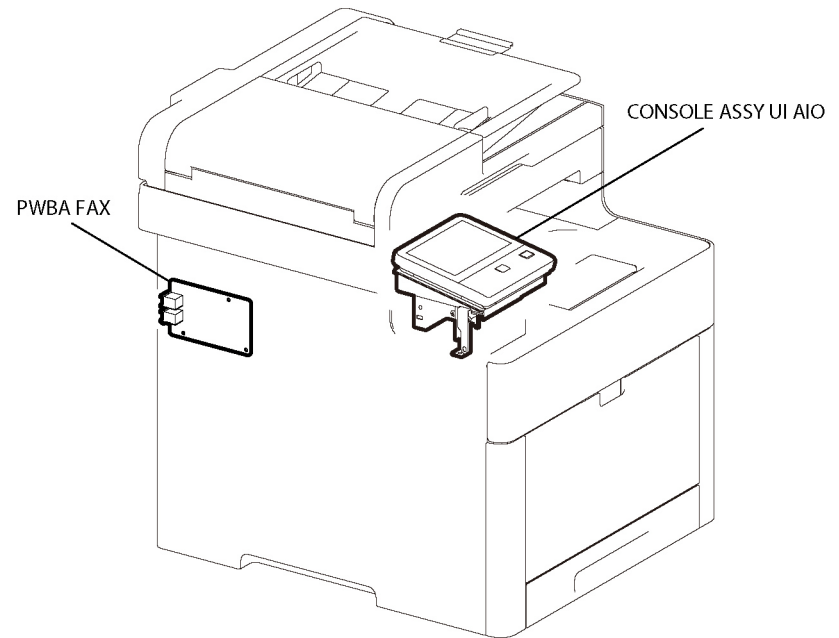
Figure 15 UI and FAX Function

The board for controlling the FAX signal.

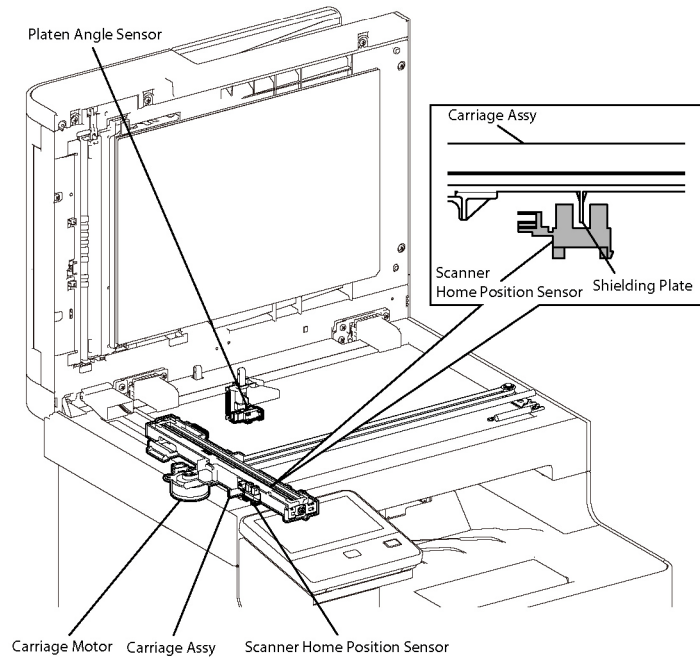
Figure 16 Scanner IIT Function

- **Carriage Motor (Scanner Motor)**
The stepping motor that drives the Carriage Assy.
- **Scanner Home Position Sensor (CVT Position)**
As part of the rear side of the Carriage Assembly frame, the sensor functions as an actuator and blocks the light on the Scanner Home Position Sensor, thus detecting the registration position. This sensor detects the home position of the Carriage Assembly. When the Carriage Assembly is in the home position, the light is shielded, and when not in the home position, the light is unshielded.
- **Platen Angle Sensor**
Detects when the platen is open/closed.

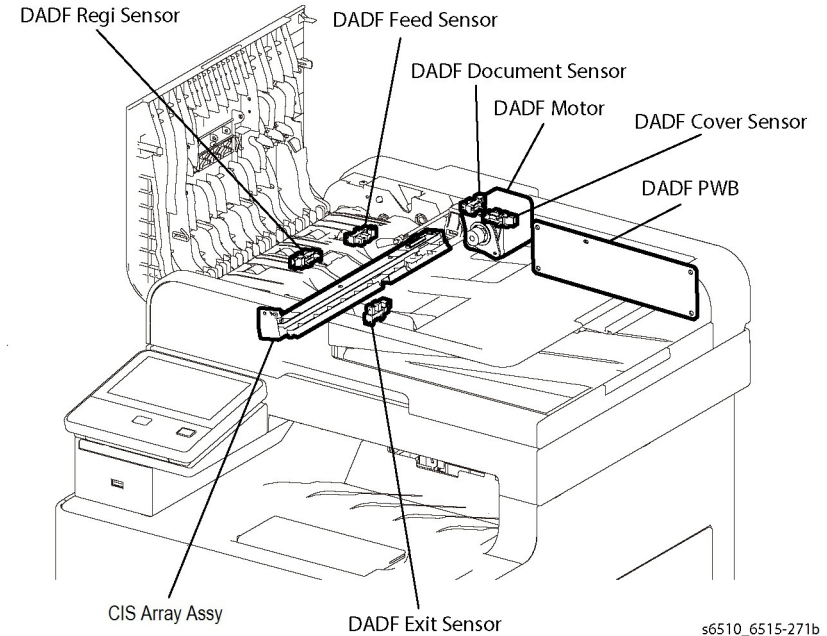
Figure 17 Scanner DADF Function

- **CIS Array Assembly**
Scans the image on the back side of the document in the duplex mode.

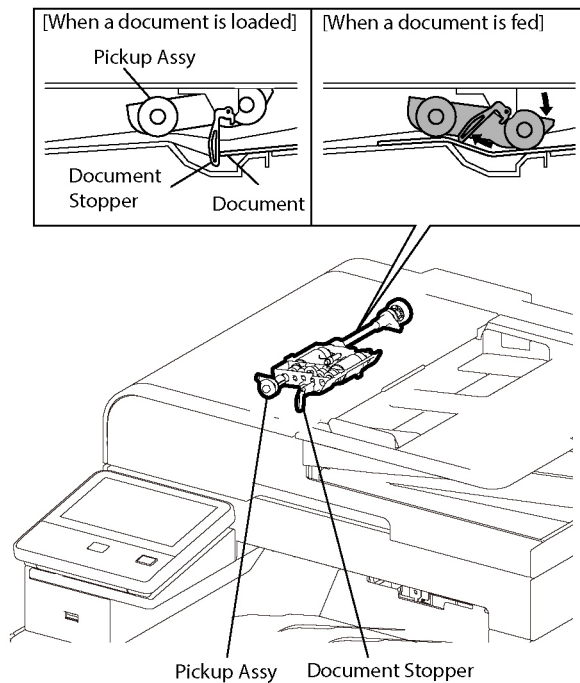
- **DADF Board**
Controls the whole DADF system.
- **Document Stopper**
When a document is loaded in the DADF, the Document Stopper is locked to prevent the document from being moved forward.
When the DADF starts feeding, the front portion of the Pickup Assembly is lowered. This unlocks the Document Stopper that blocks the document. When the Document Stopper is pressed by the lead edge of the document in the feed direction, the document is fed. When the paper feed is completed, the Pickup Assembly returns to its original position.

Figure 18 Document Stopper Function

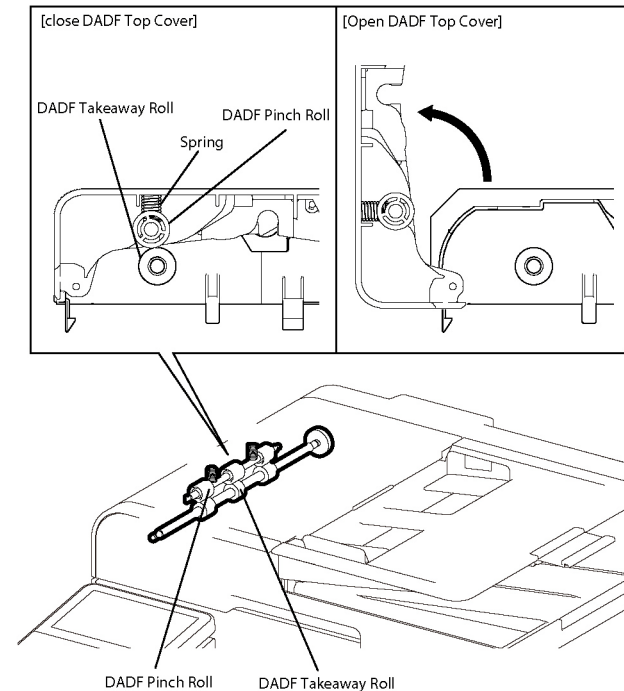
- **DADF Pinch Roll**
The DADF Pinch Roll is normally pressed against the direction of the DADF Takeaway Roll by the spring pressure.
Documents are fed between the DADF Pinch Roll and the DADF Takeaway Roll to the CVT Window by the rotation of the DADF Takeaway Roll.
If a jam occurs between the DADF Pinch Roll and the DADF Takeaway Roll, it is hard to retrieve documents due to the high spring pressure of DADF Pinch Roll.
To retrieve jammed documents, open the DADF Top Cover to release the spring pressure, and make enough clearance between the DADF Pinch Roll and the DADF Takeaway Roll.

Figure 19 DADF Pinch Roll Function

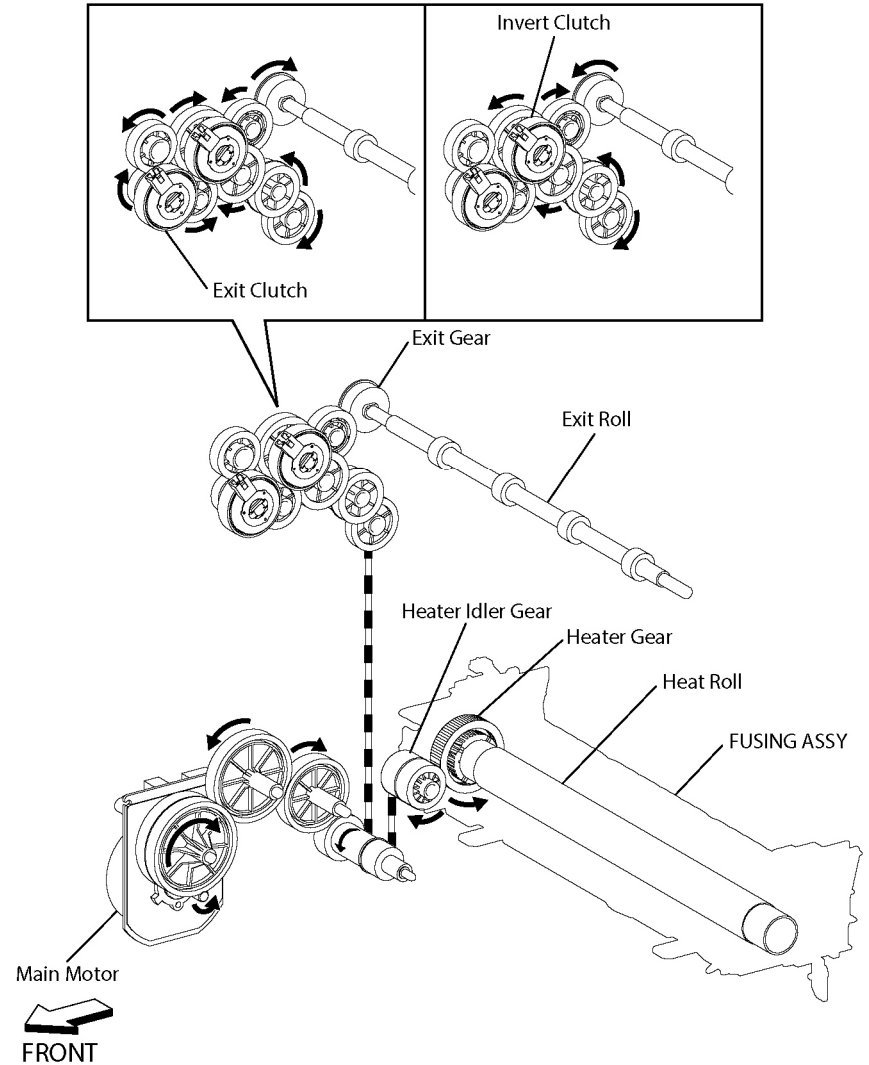
Figure 2 Paper Feed (Fuser to Exit)

Figure 2 shows the drive transmission from the Fuser section to the exit section, where the rolls and gears are driven by the Main Motor.

↻ : Direction of the gear rotation
 - - - : Drive transmission route

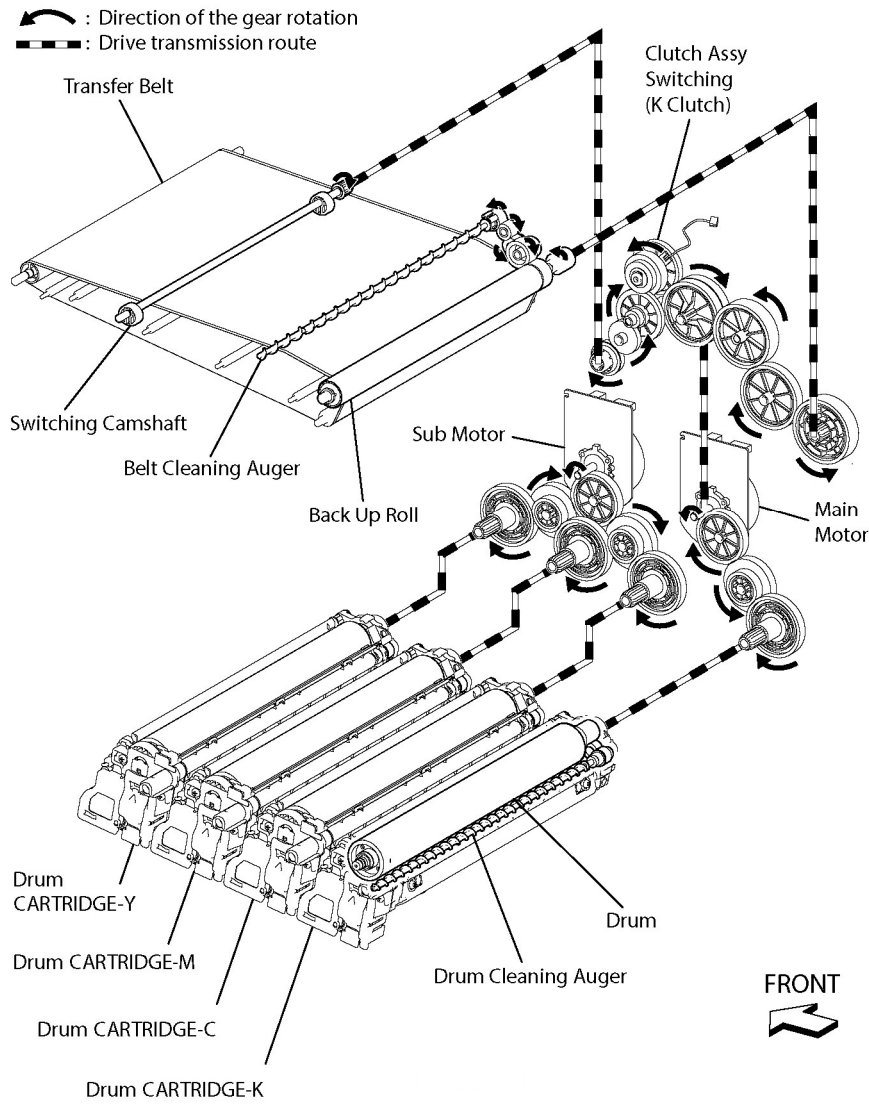
Figure 3 Drum and Transfer Belt Feed

Figure 3 shows the drive transmission of the Drum and the Transfer Belt. The Main Motor drives the rolls and gears of the Drum (K) and the Transfer Belt. The Sub Motor drives the rolls and gears of the Drums (Y/M/C).

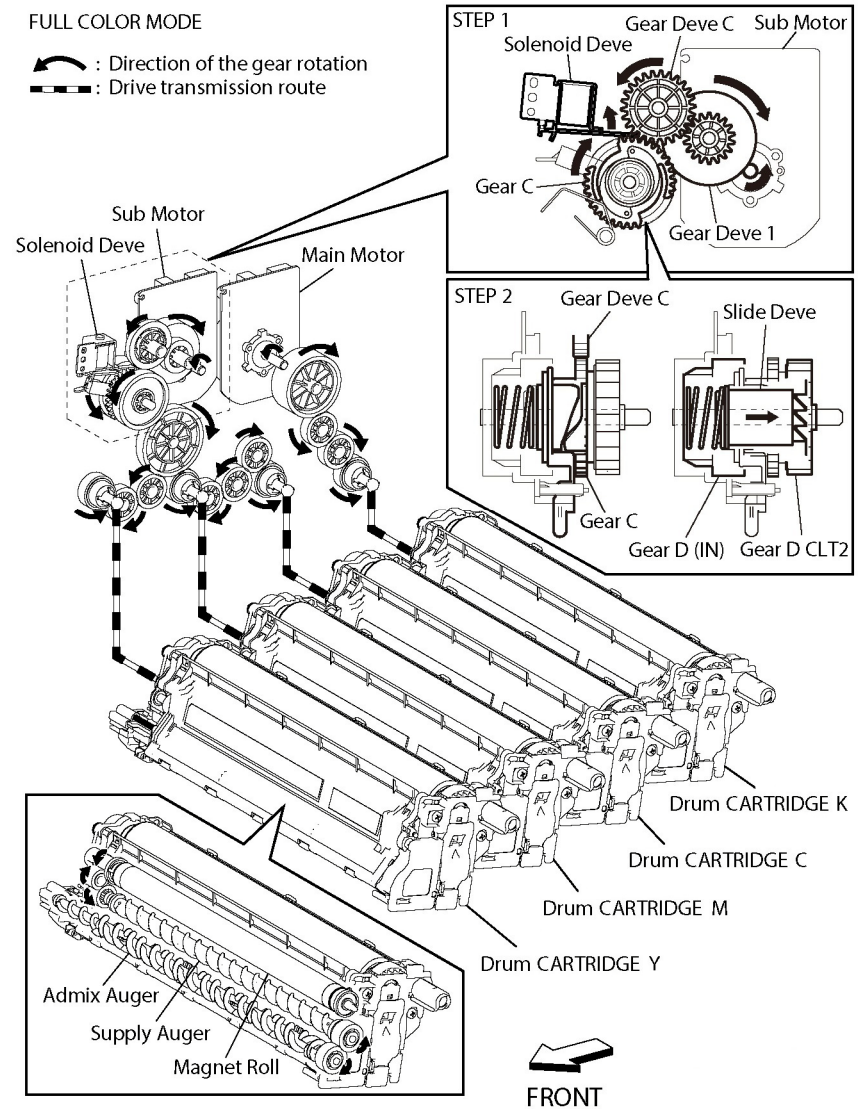
Figure 4 Development Feed Color Mode

Figure 4 and Figure 5 show the drive transmission of the development components for full color mode and for monochrome mode. The Main Motor drives the rolls and gears of the development components (K). The Sub Motor drives the rolls and gears of the development components (Y/M/C).

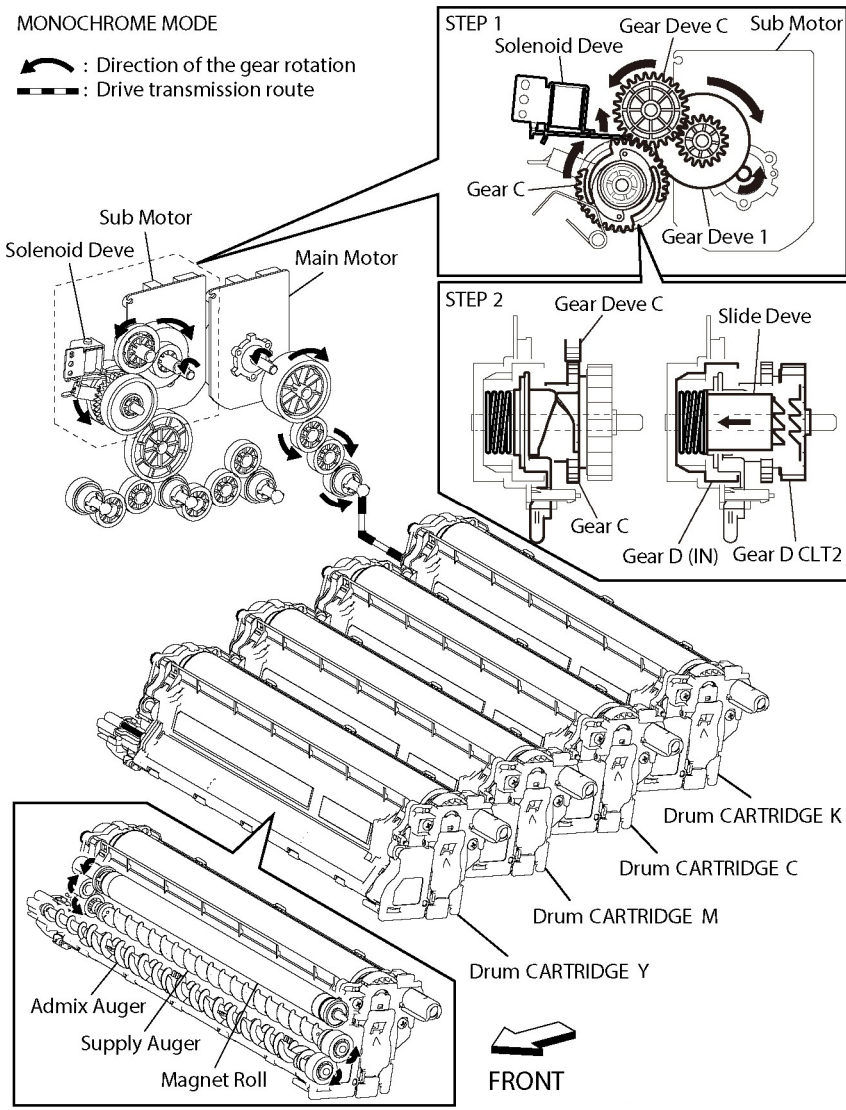
Figure 5 Development Feed Monochrome Mode

MONOCHROME MODE

↻ : Direction of the gear rotation
 - - - : Drive transmission route

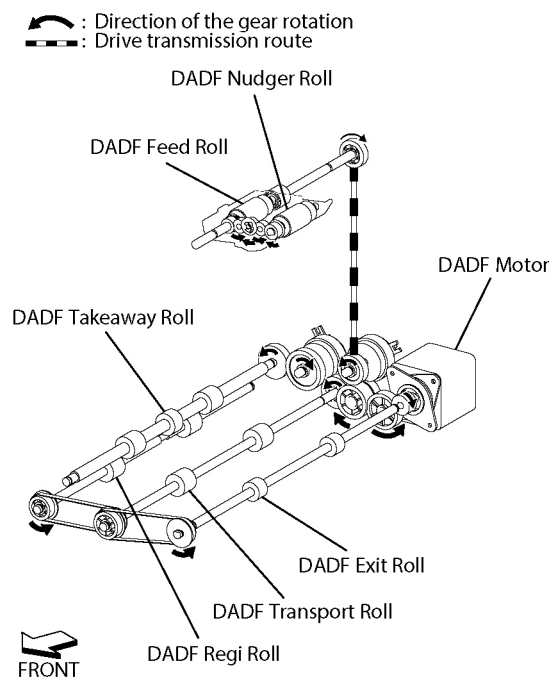
Figure 6 DADF Motor

Figure 6 shows the drive transmission route from the DADF Motor to each roller.

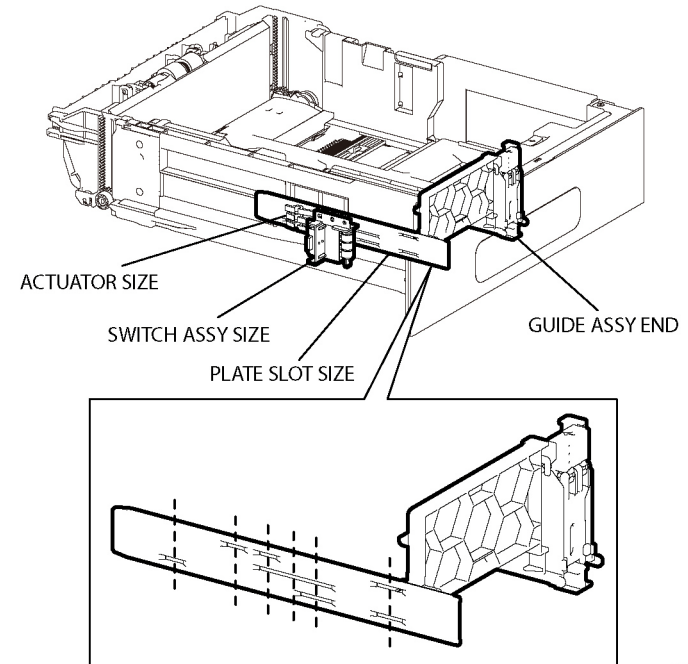
Figure 2 Option Feeder Size Switch

Detects paper size, and presence or absence of paper in the 550 paper cassette.

Load paper in the paper cassette, and adjust the Left Guide Assembly, Right Guide Assembly, and End Guide Assembly to the paper size. Linked with the End Guide Assembly, the position of the Size Slot Plate is changed, and the three Size Actuators on the side of the cassette depress the Size Switch Assembly. The detected paper size corresponds to the combination of actuators depressing the Size Switch.
