# VersaLink® B600/B610 Printer and B605/B615 Multifunction Printer Service Manual

Xerox® VersaLink® B600 Family MFP Service Manual

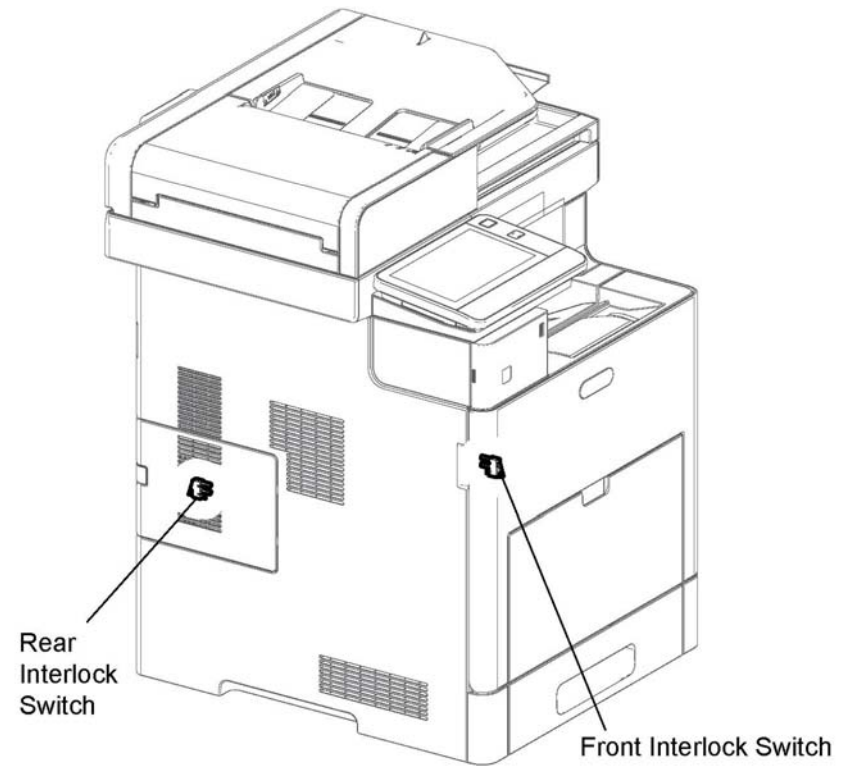
Figure 1 Safety interlock switch locations (MFP shown)

Use caution so that the safety devices for preventing accidents (interlocks switches, fuses, thermostats, etc.) and the protective parts for users (covers, control panel, etc.) can function as intended. Make sure all covers are in place and all interlock switches are functioning correctly after you have completed a service call. If you bypass an interlock switch, use extreme caution when working on or around the printer. [Figure 1](#) and [Figure 2](#) show the interlock switch locations and circuitry.

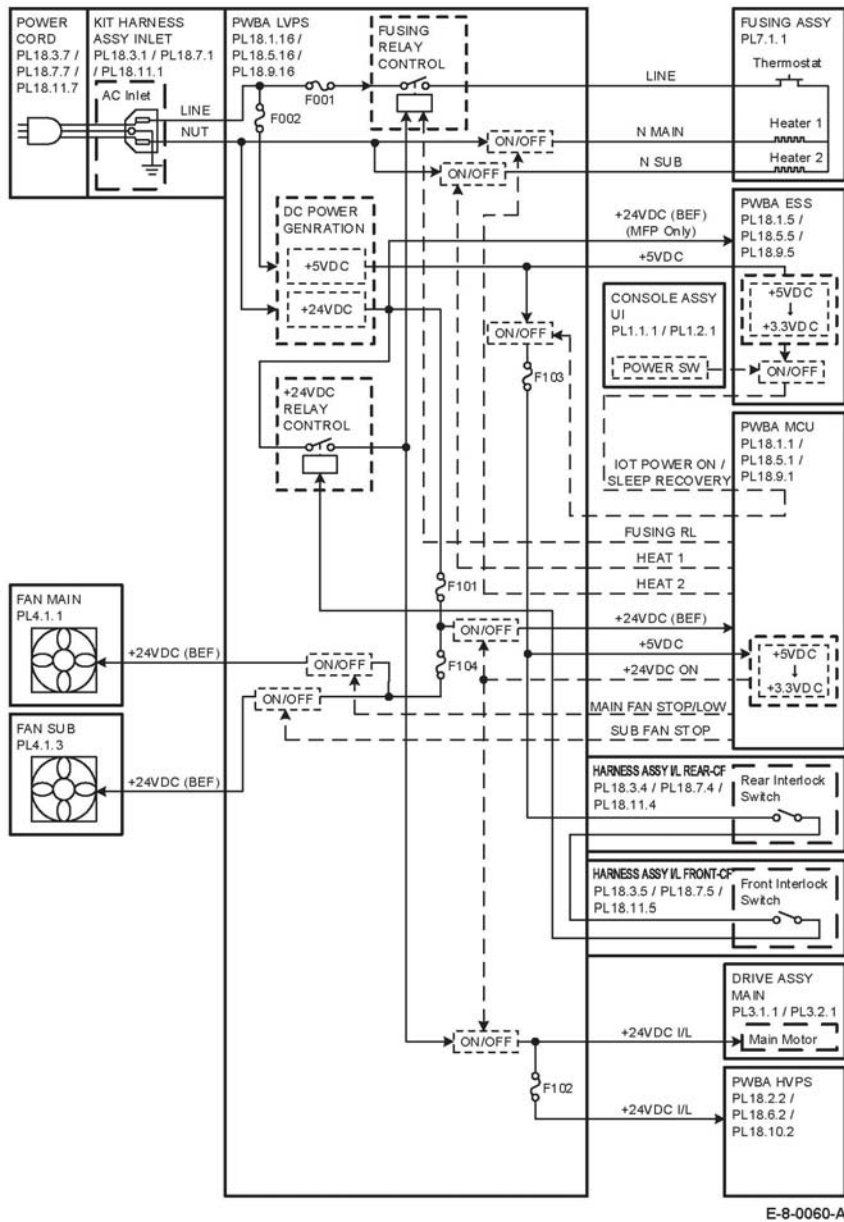
Figure 2 Safety system schematic

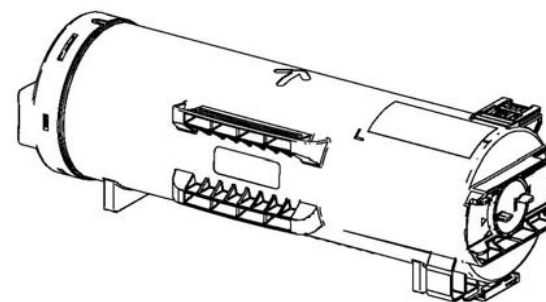
E-8-0579-A

Figure 1 Toner cartridge

Consumable	Width (mm)	Depth (mm)	Height (mm)	Mass (g)
Toner Cartridge (Figure 1.)	61.3	180	57.3	100/120/140
Drum Cartridge (Figure 2.)	77.3	335.4	78.5	720

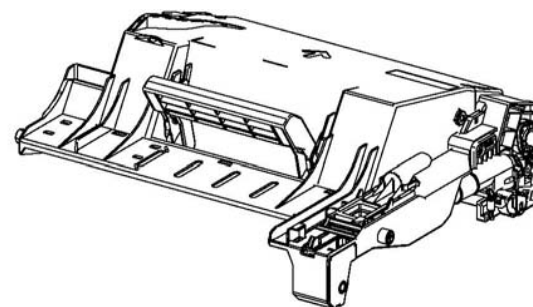
E-8-0580-A

Figure 2 Drum cartridge

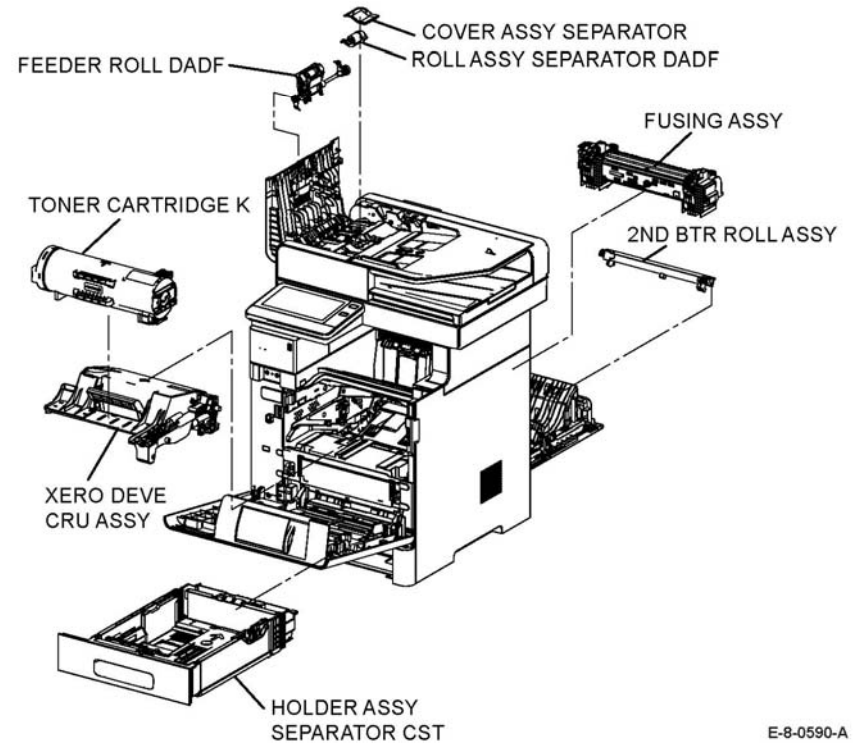
E-8-0590-A

**Figure 3 MFP routine maintenance items**

For routine maintenance items, refer to [Figure 3](#) and [Figure 4](#) for the MFP, and to [Figure 5](#) for the SFP.

- Fuser (110V / 220V): 200 kPV
- Transfer belt unit and transfer roller unit: 200 kPV
- DADF feed rollers: 200 kPV (VersaLink C505/C605 MFP only)

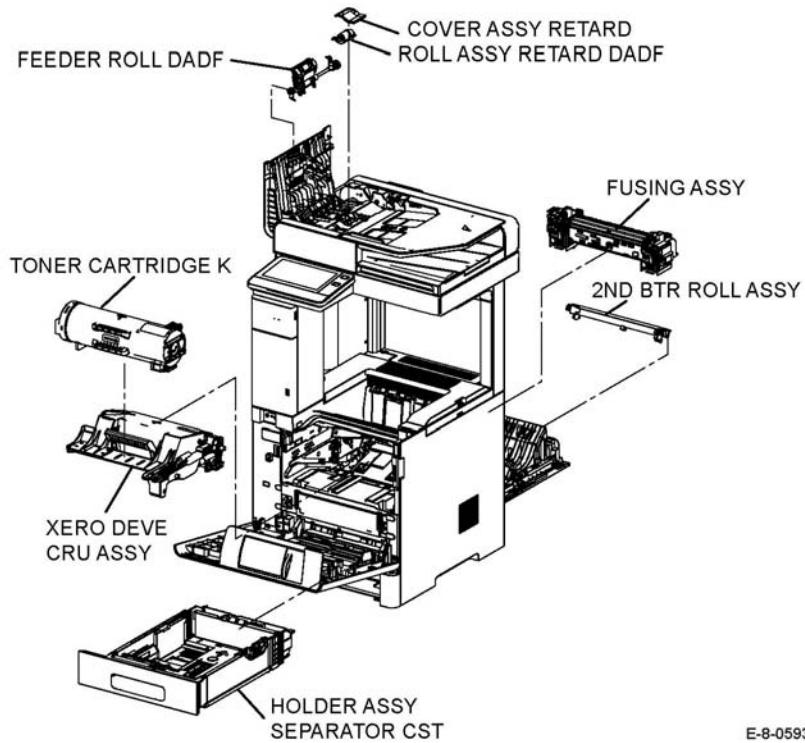
E-8-0593-A

Figure 4 MFP\_Tall routine maintenance items

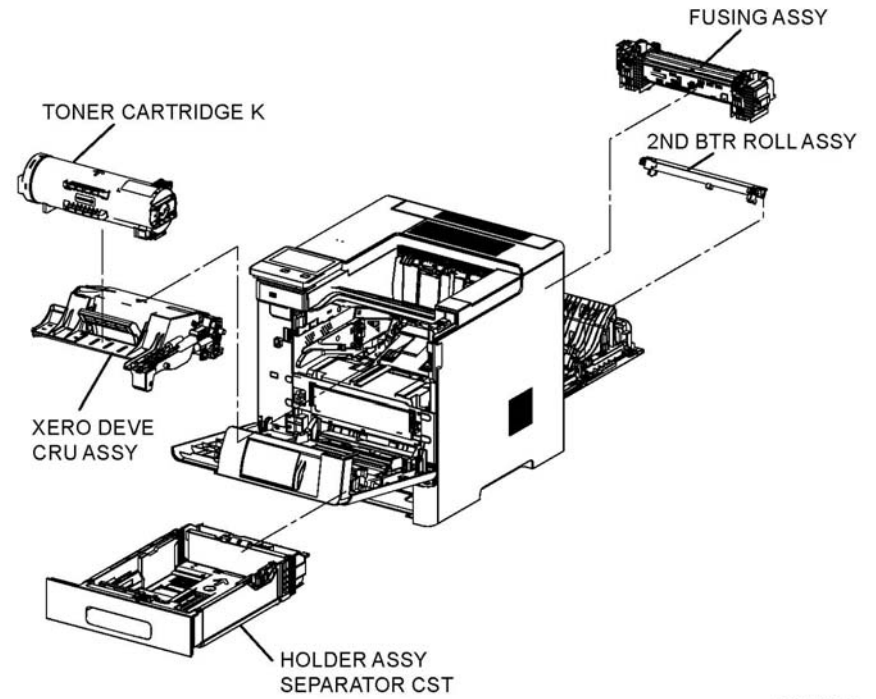
E-8-0594-A

Figure 5 SFP routine maintenance items

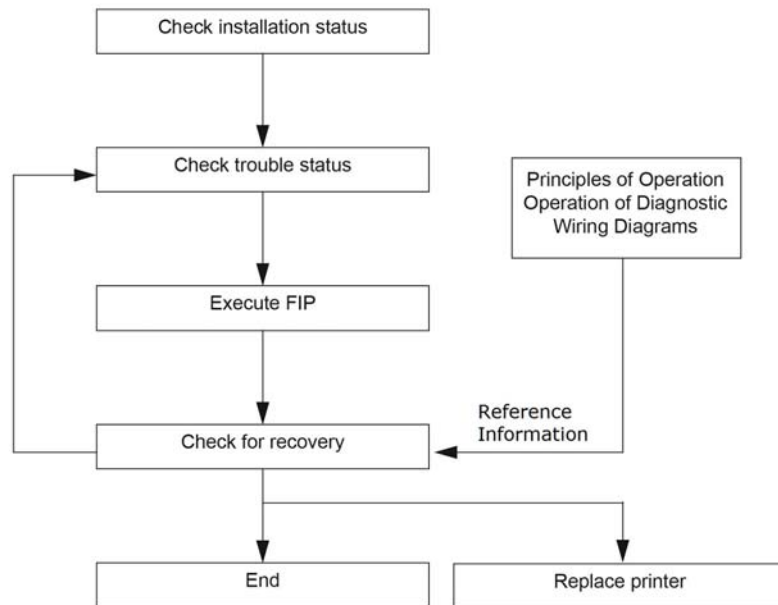
Flow of the troubleshooting is as follows:

Figure 1 Troubleshooting Flow Diagram

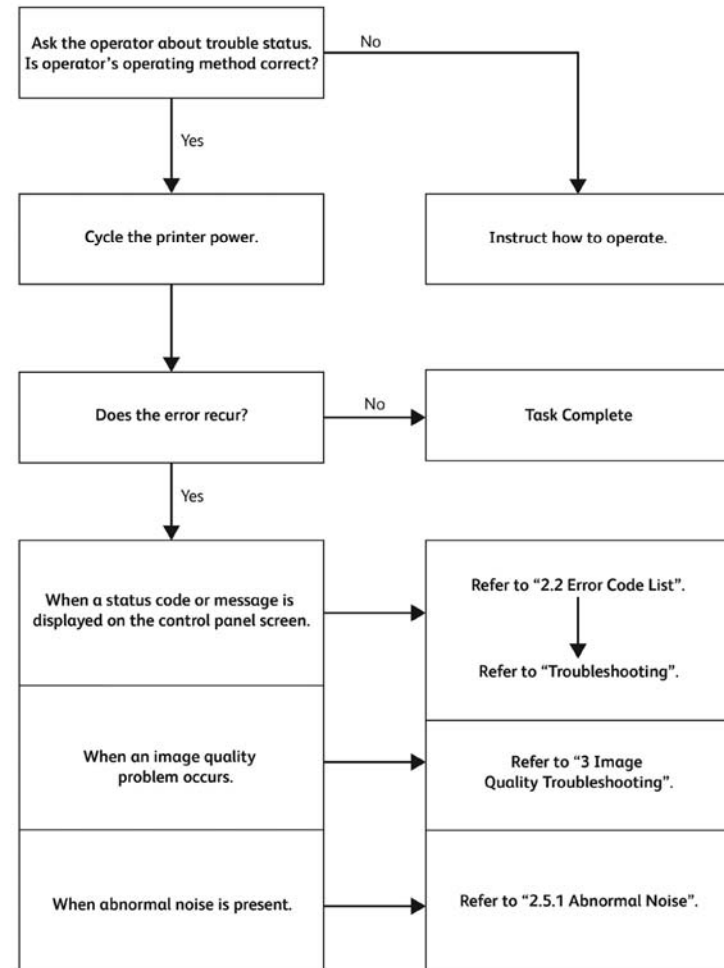
The RAP is the first step for trouble diagnosis. The RAP isolates the presence of various troubles including error codes, and guides the troubleshooting procedure.

**Figure 2 Repair Analysis Process**

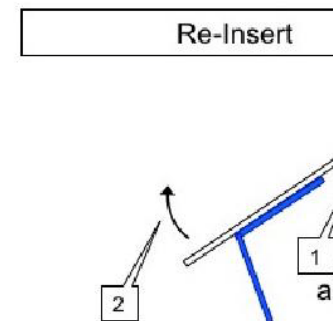
**NOTE:** When engaging the release lever on the FFC connector, slightly open the release lever no more than 15 degrees. Hold the lever while gently removing the FFC from the connector as shown in Figure 1, **Proper FFC Cable Removal**.

Figure 1 Proper FFC Cable Removal

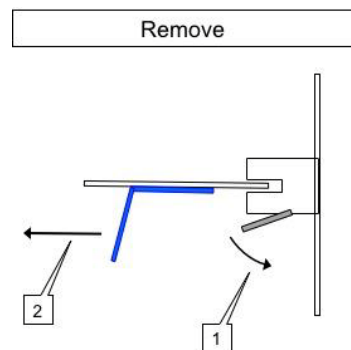
**NOTE:** When engaging the release lever on the FFC connector, slightly open the release lever no more than 15 degrees. Hold the lever while gently removing the FFC from the connector as shown in Figure 1, **Proper FFC Cable Removal**.

Figure 1 Proper FFC Cable Removal

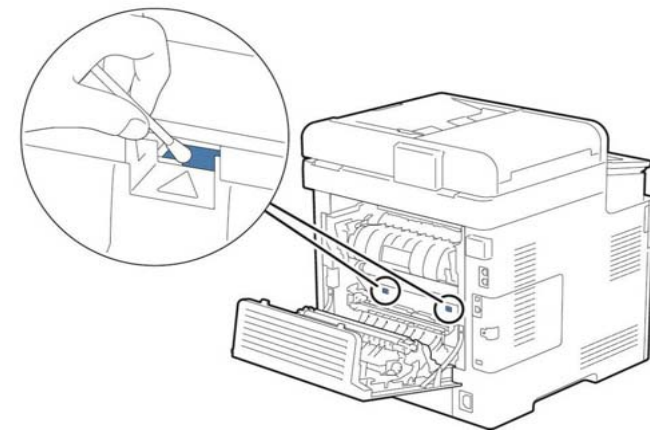
1. Turn the printer off, GP 4
2. Pull up the handle lever of the rear cover, and open the rear cover.
3. Clean the CTD sensor with a clean and dry cotton swab.

Figure 1 Cleaning the CTD sensor

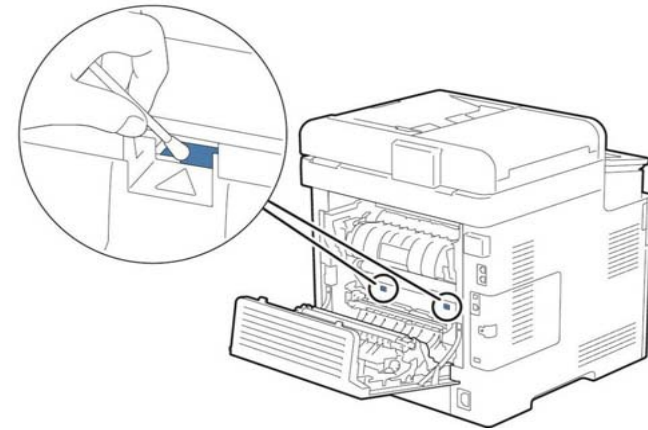
1. Turn the printer off, GP 4
2. Pull up the handle lever of the rear cover, and open the rear cover.
3. Clean the CTD sensor with a clean and dry cotton swab.

Figure 1 Cleaning the CTD sensor

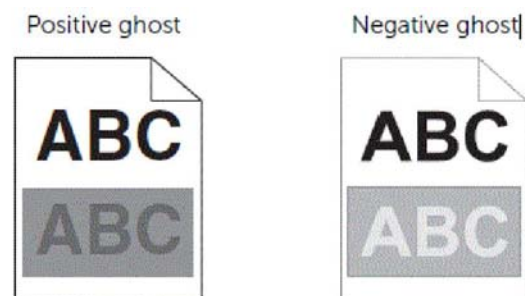
E-8-0191-A

Figure 1 Ghosting example

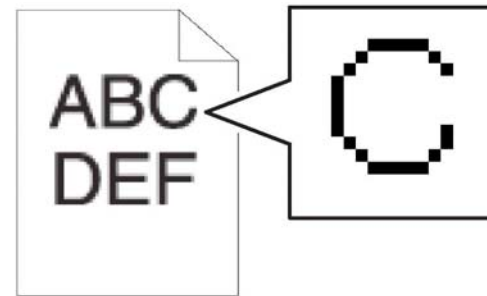
E-8-0179-A

Figure 1 Jagged/ blurry text and image example

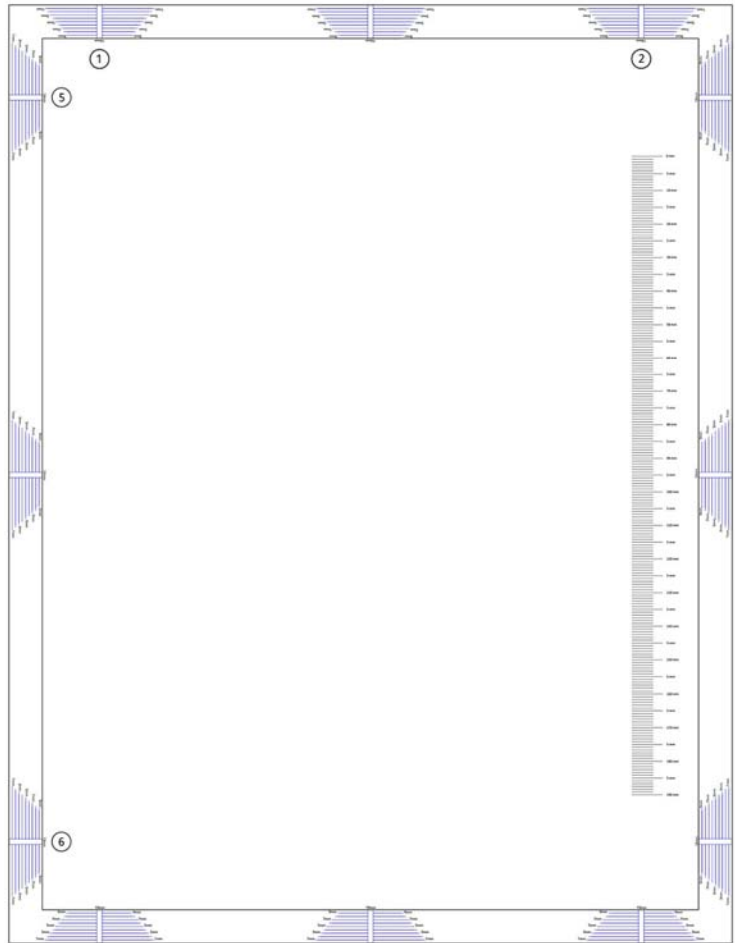
B-1-0360-A

Flatbed Copy (From Platen)	DADF Copy	IIT Scan from platen to file	IIT + DADF (Scan) Scan to file	IOT (Internal Print)
Lead Edge (180mm edge)	±1.3mm	±2.7mm	±0.6mm	±2.4mm	±1.1mm
Side Edge (280mm edge)	±2.2mm	±3.5mm	±0.9mm	±2.8mm	±2.0mm

**Figure 1 Skew Check**

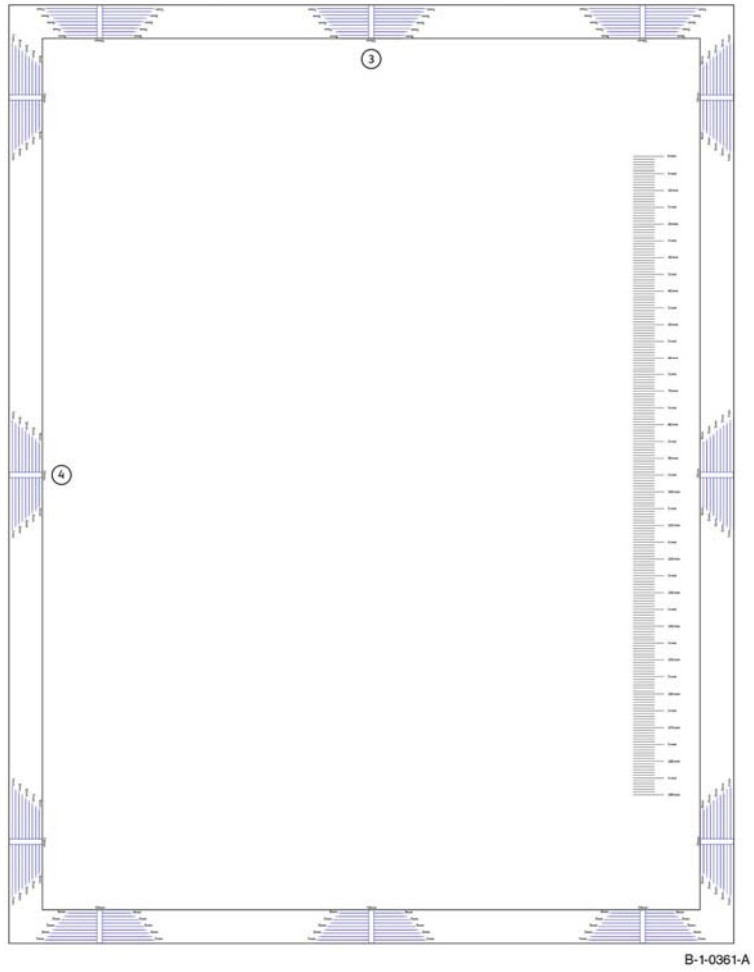
Flatbed Copy (From Platen)	DADF Copy	IIT Scan from platen to file	IIT + DADF (Scan) Scan to file	IOT (Internal Print)
Lead Edge (180mm edge) Registration	+3.3/-1.3mm	±3.9/-1.9mm	±1.0mm	±2.0mm	+3.0/-1.0mm
Side Edge (280mm edge) Registration	±2.7mm	±3.0mm	±1.0mm	±1.5mm	±2.5mm

**Figure 1 Registration Check**

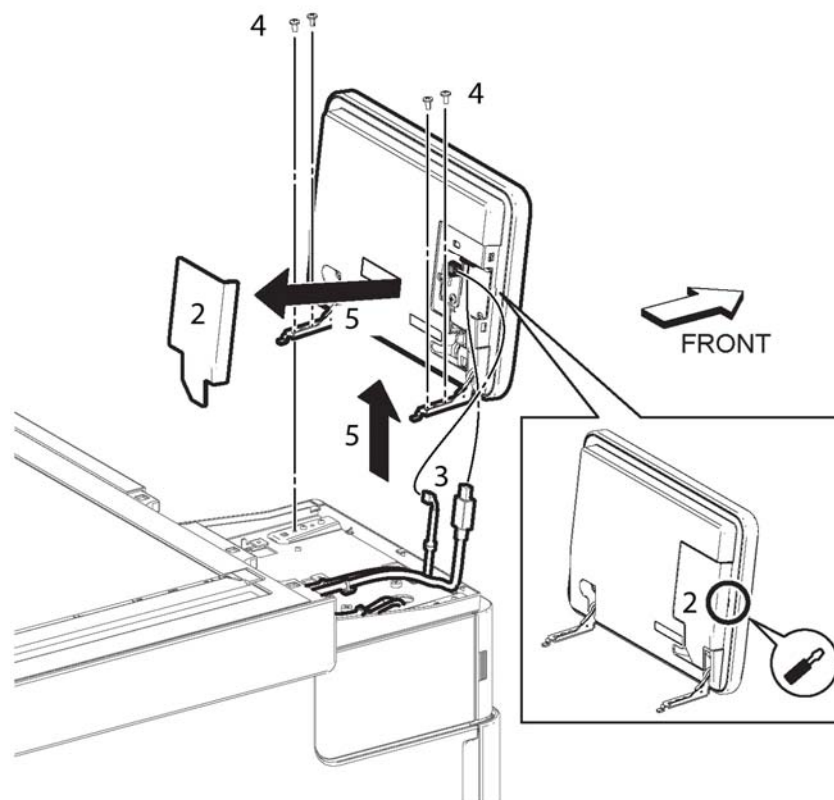
D-8-0012-A

1. Verify the software version, if possible, before and after replacement of the UI and update the software, [GP 9](#), if needed.
2. Remove the UI console assembly, [Figure 1](#):
  - a. Remove the UI access door (2) from the console, [REP 1.5](#).
  - b. Release the UI and the speaker harness (3) from the UI console assembly.
  - c. Remove four screws (4) attaching the UI console assembly (5) to the UI frame assembly.
  - d. Remove the UI console assembly (5) from the UI frame assembly.

Figure 1 UI console assembly

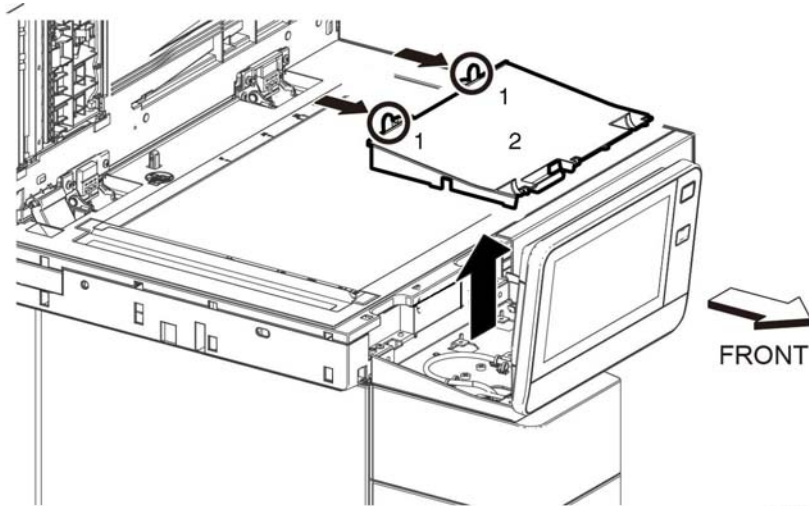
D-8-0017-A

1. Remove the left side IIT cover, [REP 50.5](#).
2. Release two hooks, and remove the UI inner cover, [Figure 1](#).

Figure 1 UI Inner cover

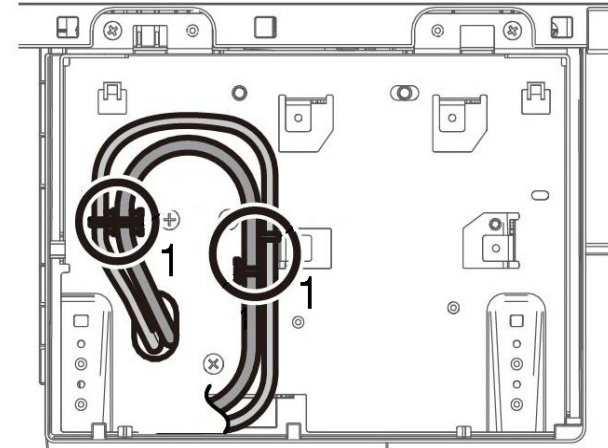
1. Remove the IU inner cover, [REP 1.2](#).
2. Release four push ties (1) attaching the harnesses, [Figure 1](#).

Figure 1 Release push ties

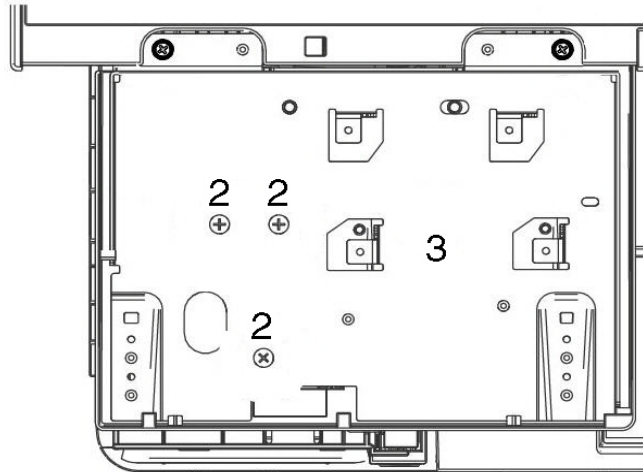
3. Remove three screws (2), then remove the UI frame inner cover (3), [PL 1.1 Item 3](#).

Figure 2 UI frame cover screws

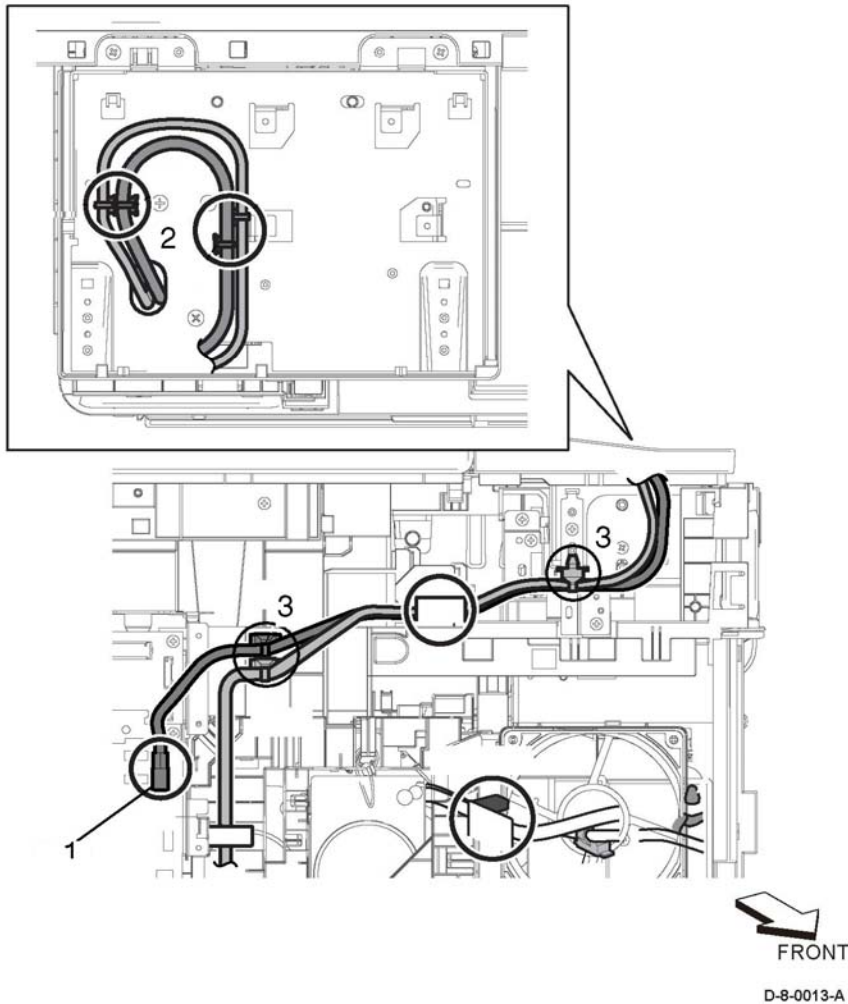
D-8-0013-A

Figure 1 UI harness

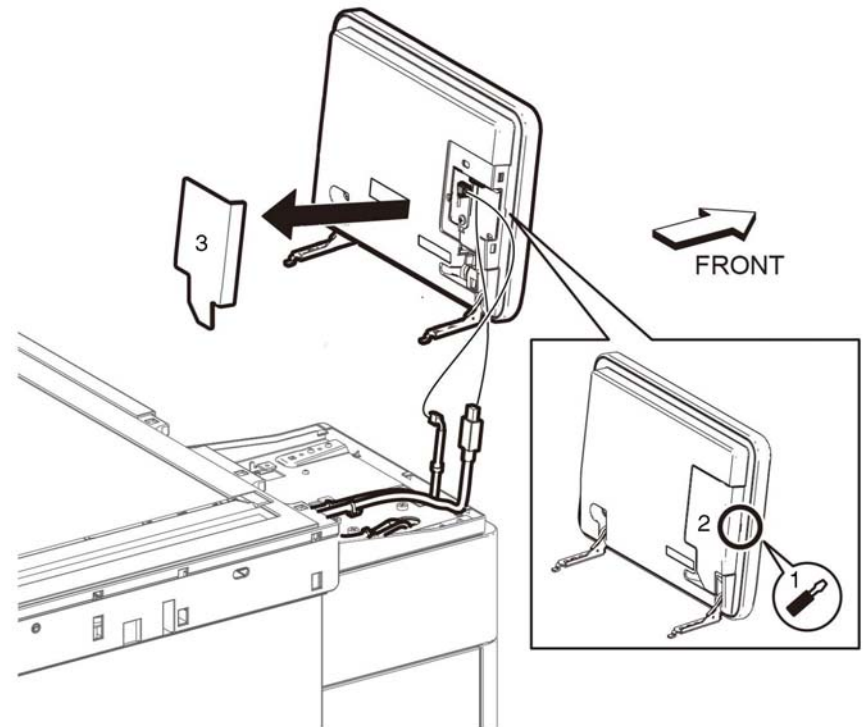
D-8-0018-B

1. Insert a flat blade screwdriver (1) at the side of the UI access door (2) to slightly open the UI access door, then remove the UI access door (3).

Figure 1 UI access door

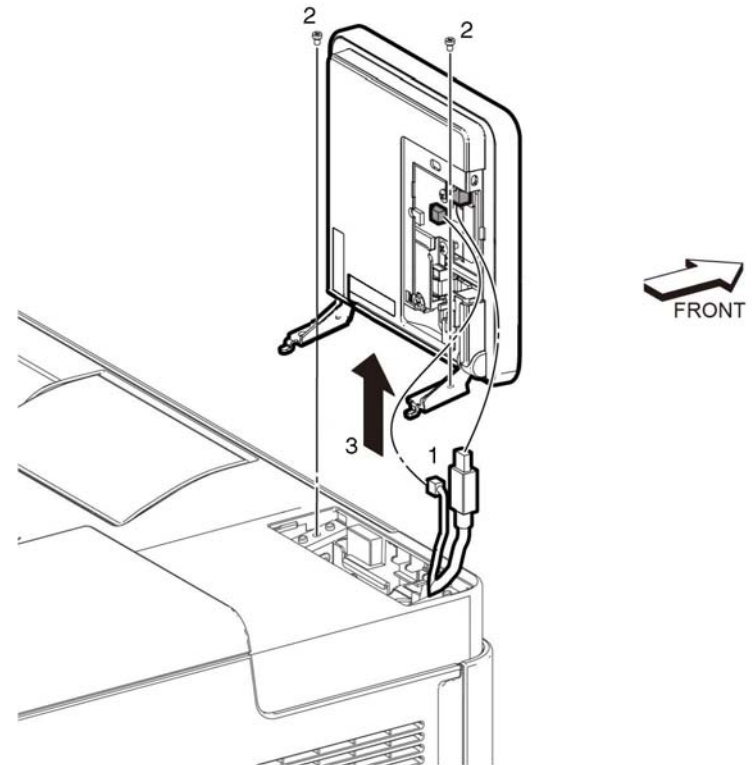
D-8-0022-B

1. Remove the UI inner cover, REP 1.7.
2. Remove the UI access door, REP 1.9.
3. Disconnect the UI and speaker harnesses (1).
4. Remove two screws (2), then lift the UI console in the direction of the arrow (3) to remove.

Figure 1 Remove the UI Console Assembly (SFP)

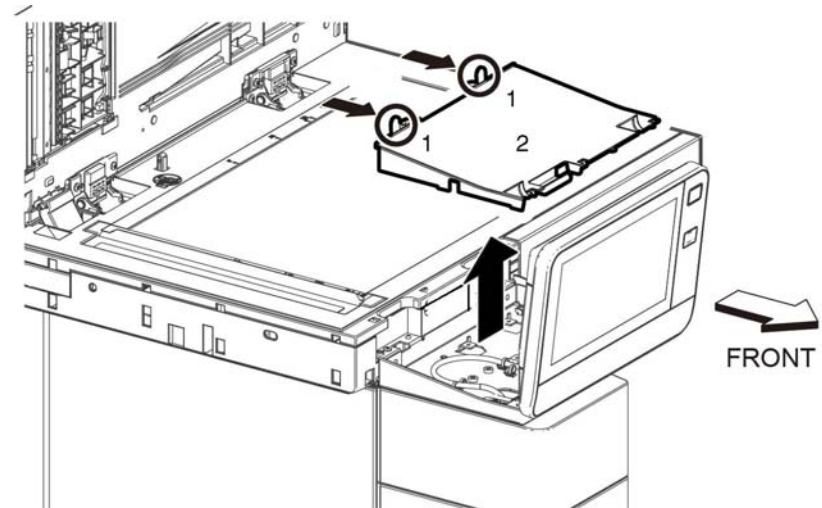
D-8-0017-A

1. Remove the left IIT cover, [REP 50.6](#).
2. Release two hooks (1) then remove the UI inner cover (2).

Figure 1 Remove the UI inner cover

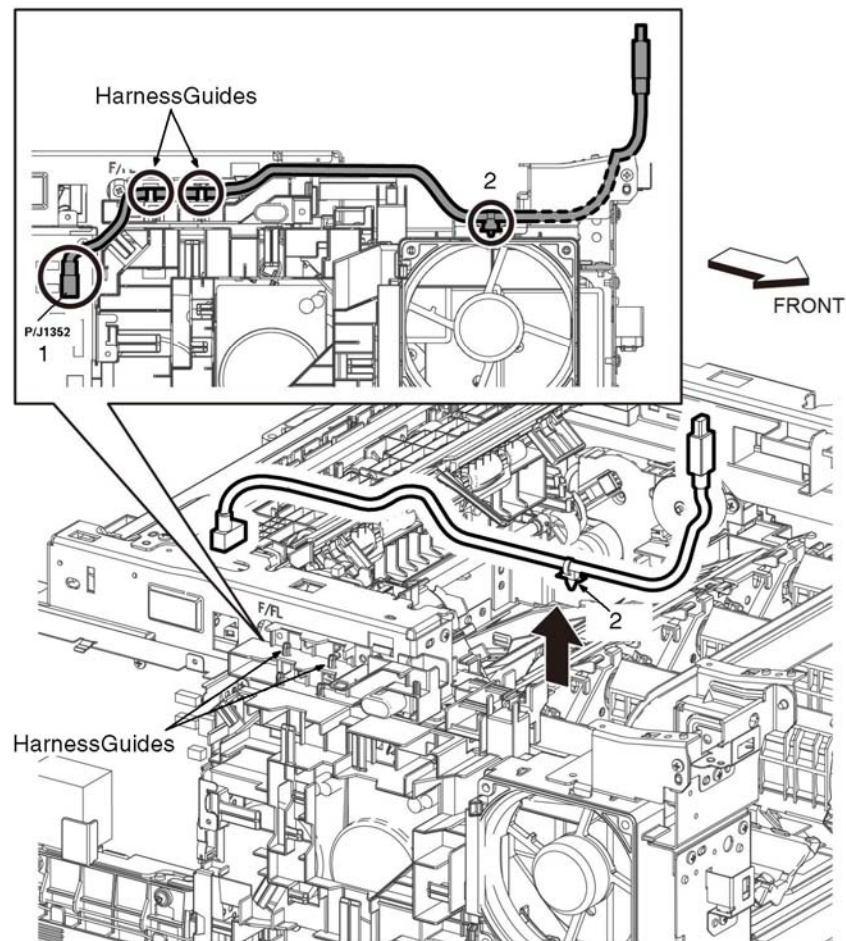
1. Remove the left side cover, [REP 19.51](#).
2. Disconnect the UI harness (1) from the ESS PWB [P/J1352](#), release the harness tab (2), then remove the UI harness.

Figure 1 Remove the UI harness assembly (SFP)

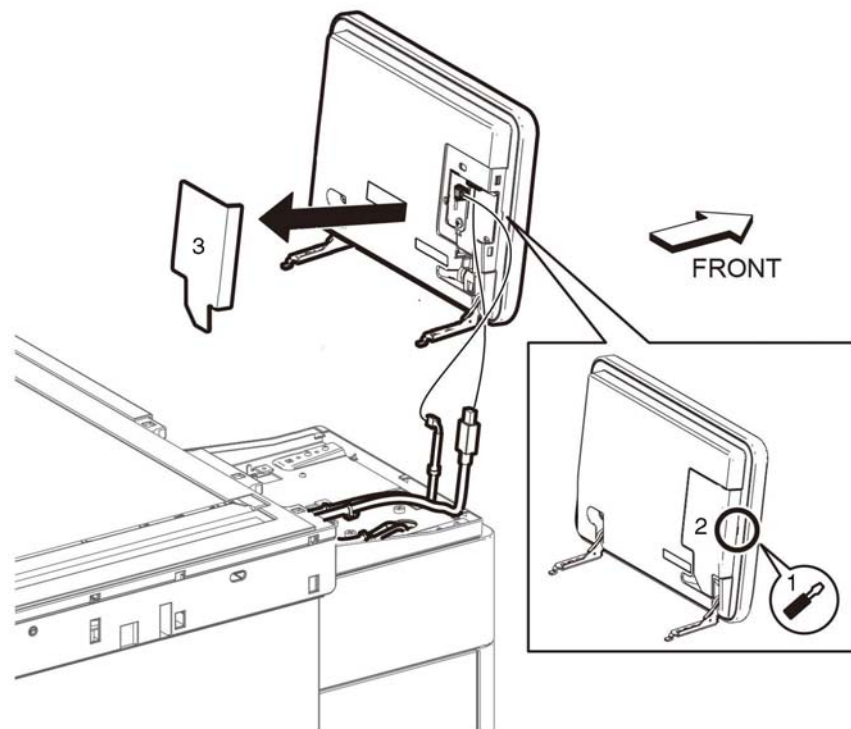
D-8-0018-B

1. Insert a flat blade screwdriver (1) at the side of the UI access door (2), then remove the UI access door (3).

Figure 1 Remove the UI access door

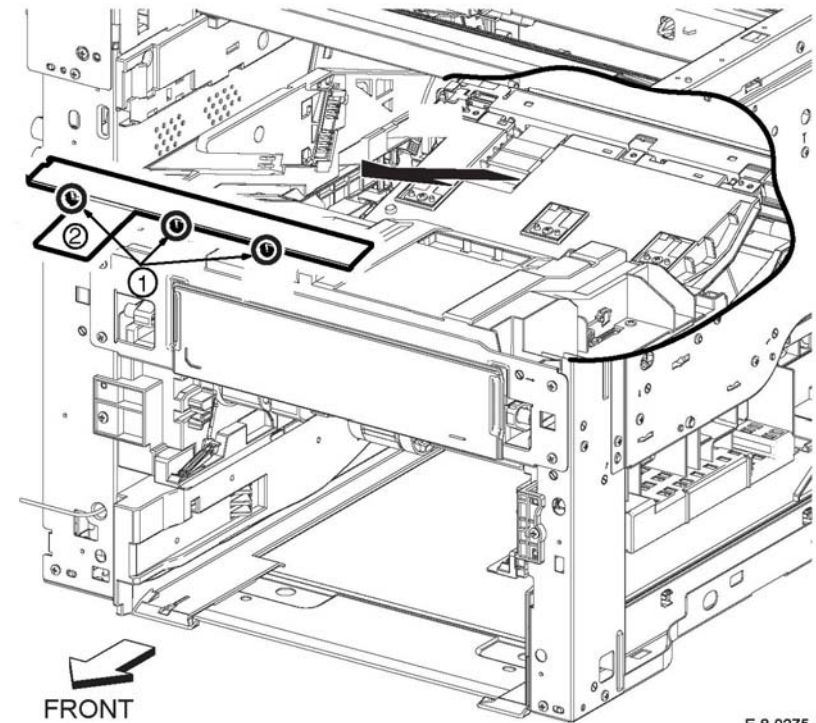
3. Remove the LPH cover, [Figure 1](#):
  - a. Remove the XERO CRU Developer Assembly, [REP 8.1](#)
  - b. Release the three hooks (1).
  - c. Remove the LPH cover (2).

Figure 1 LPH cover removal

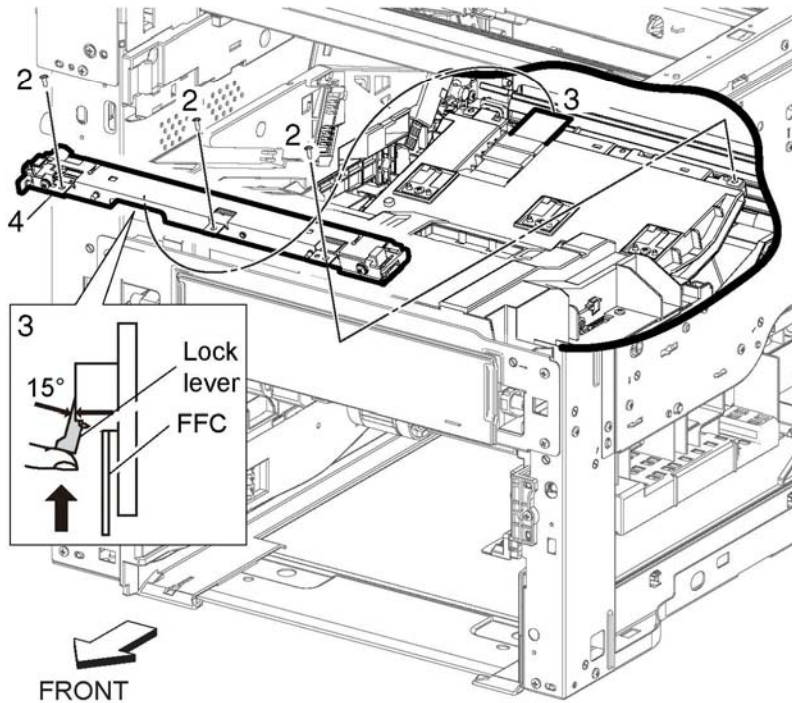
E-8-0277-A

4. Remove the LPH MONO print head, [Figure 2](#):
  - a. Remove three screws (2).

- c. Pull the LPH FFC (3) cable through hole (A), then remove the LPH FFC cable (3).

Figure 2 LPH MONO print head removal

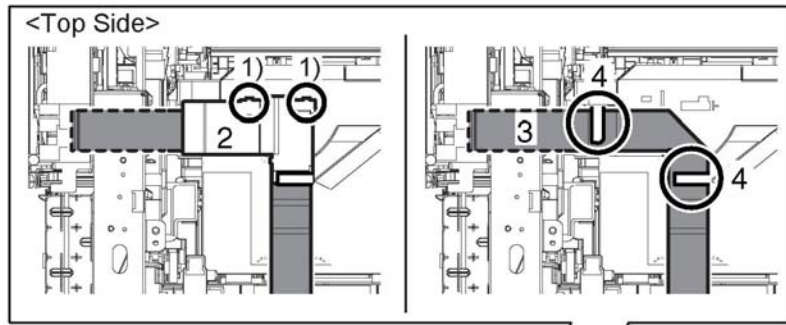
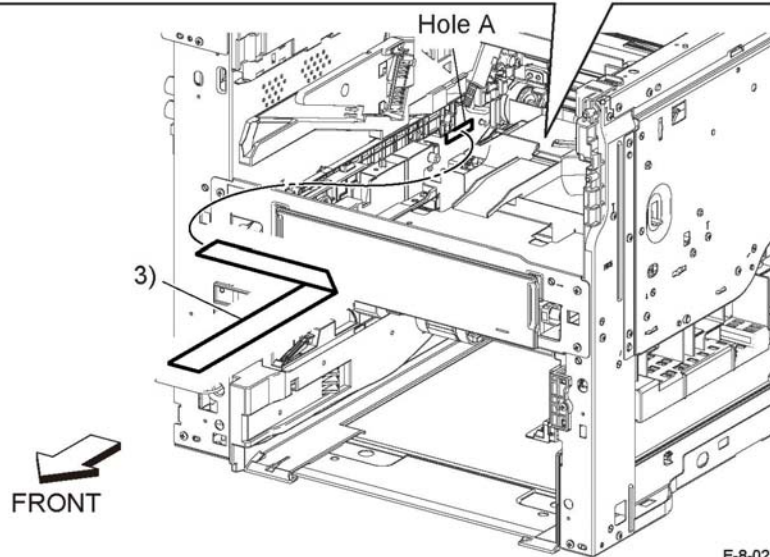
E-8-0278-A

Figure 1 LPH FFC cable removal

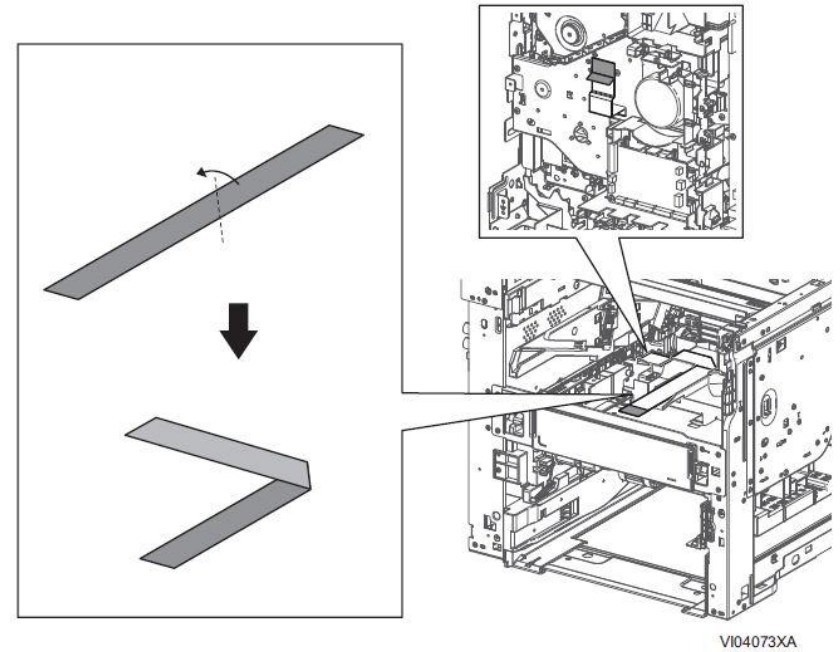
VI04073XA

Form the FFC cable, along the fold line as shown in Figure 2.

Figure 2 FFC cable installation

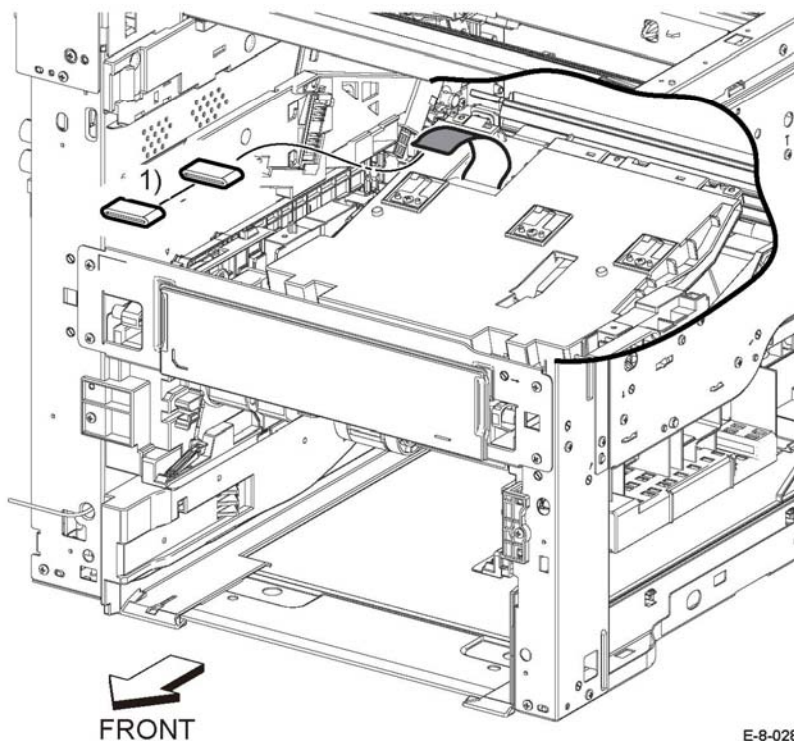
E-8-0281-A

1. Remove two LPH ferrite cores, [Figure 1](#).

Figure 1 Right LPH holder removal

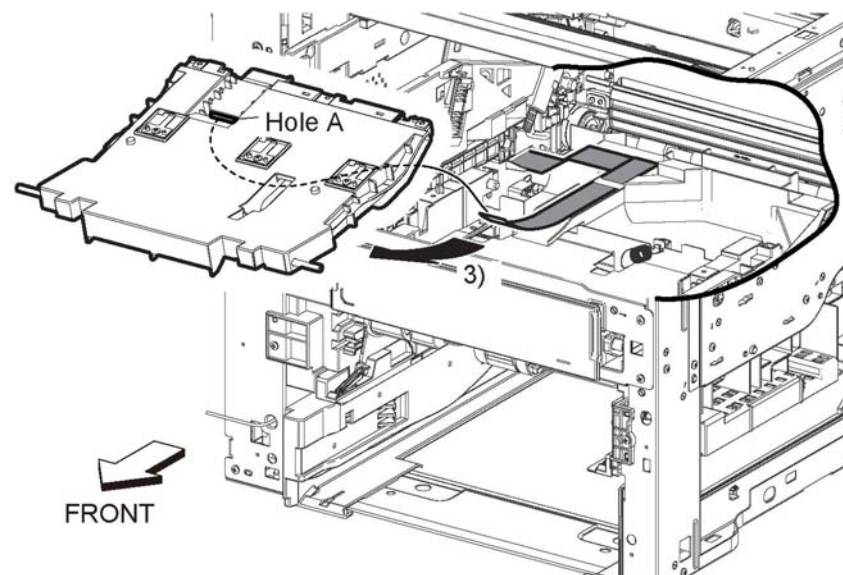
2. While working the LPH FFC cable through hole A, remove the right LPH holder, [Figure 2](#).

Figure 2 LPH FCC holder removal

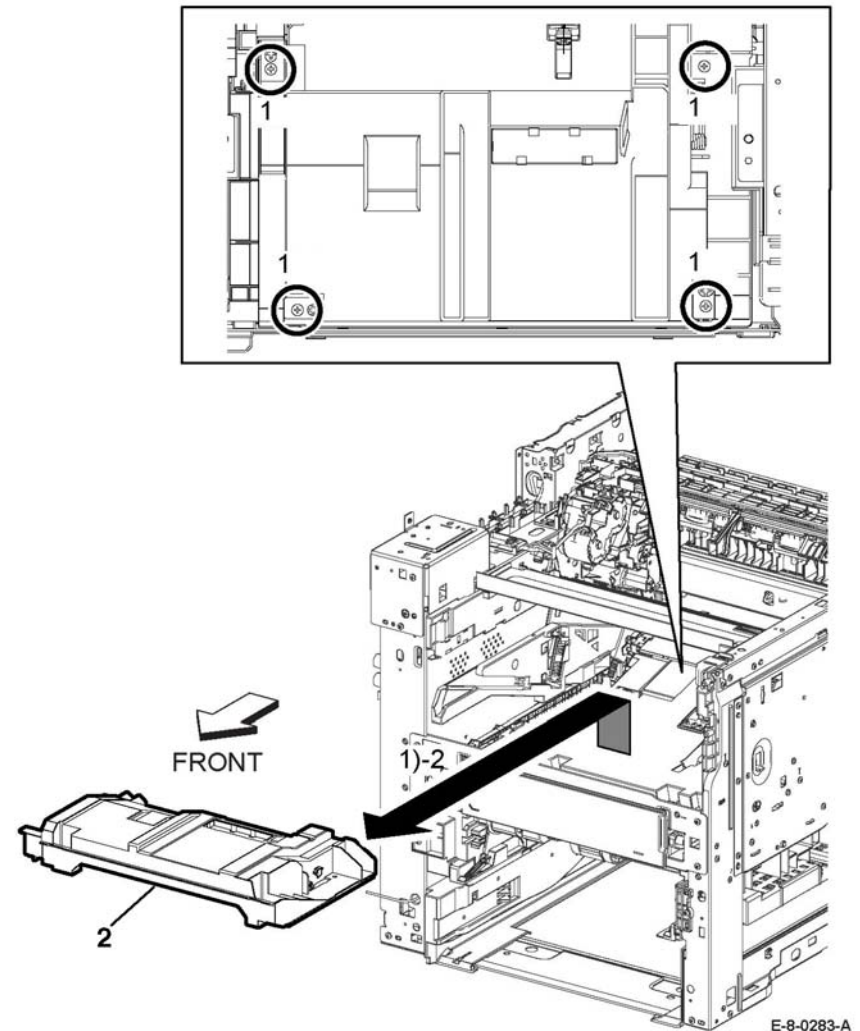
1. Remove the toner guide, [Figure 1](#):
  - a. Remove four screws (1).
  - b. Remove the toner guide (2).

Figure 1 Toner guide removal

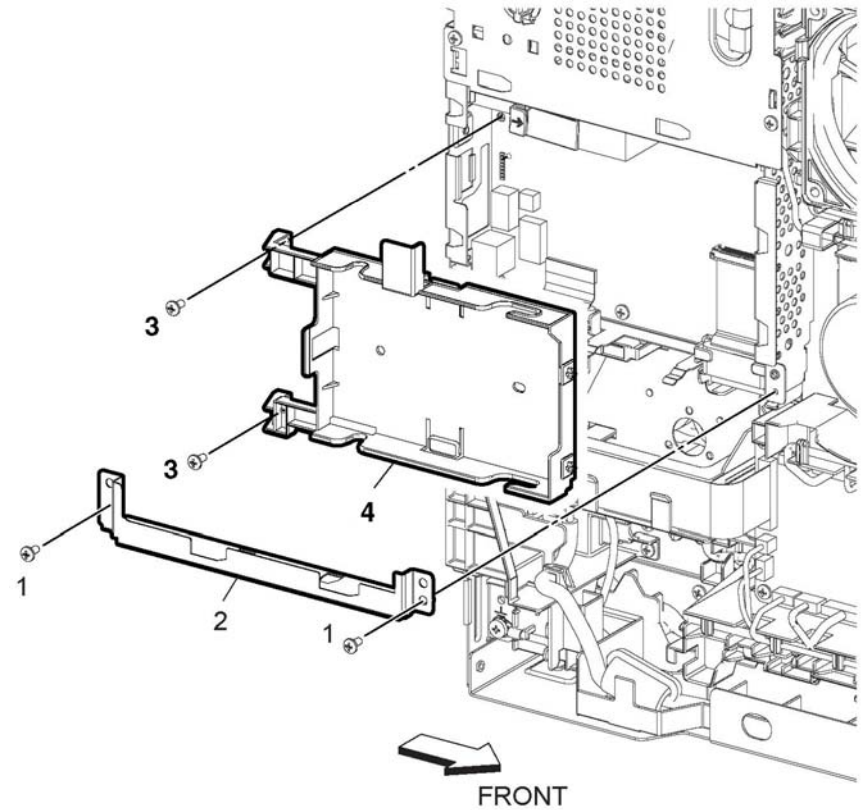
E-8-0284-A

1. Remove the lower ESS plate and HDD bracket, [Figure 1](#):
  - a. Remove two screws (1), then the lower ESS plate (2).
  - b. Remove two screws (3), then the HDD bracket (4).

Figure 1 ESS plate and HDD bracket removal

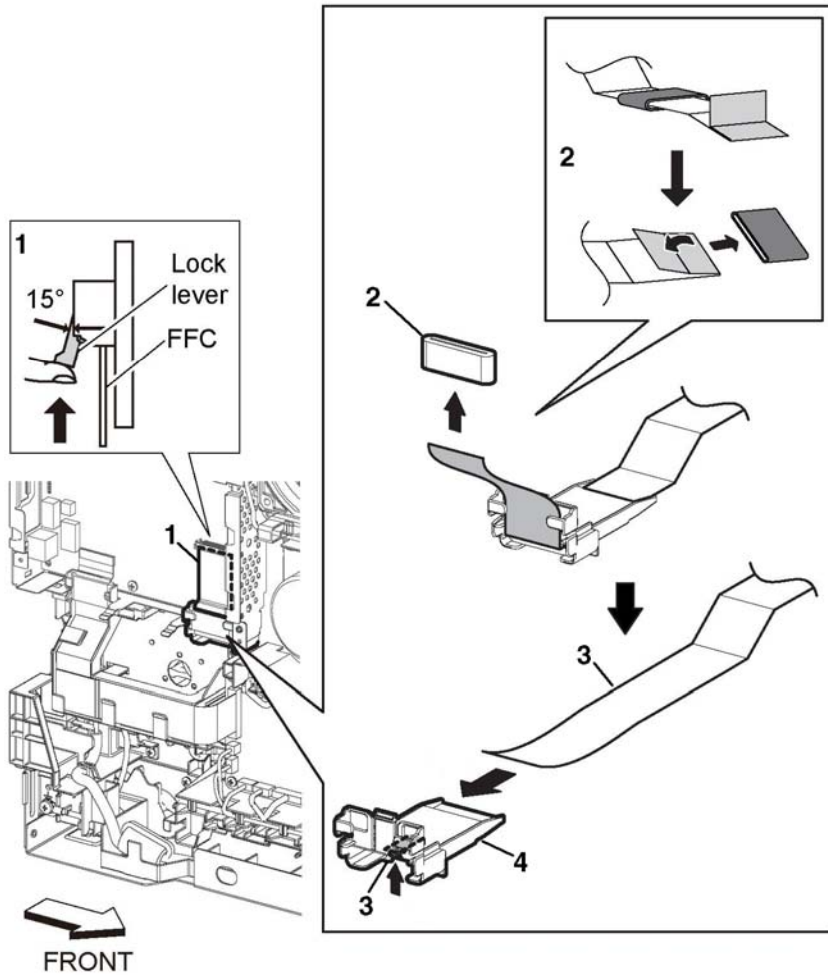
E-8-0286-A

- a. Disconnect the connector, P/J1363 (1) of the LPH FFC cable (2).
- b. Remove two LPH ferrite cores (2) from the LPH FCC cable (2).
- c. Release the lock lever (3) as shown.
- d. Remove the LPH MONO FFC guide (4).

Figure 2 LPH FCC MONO guide removal

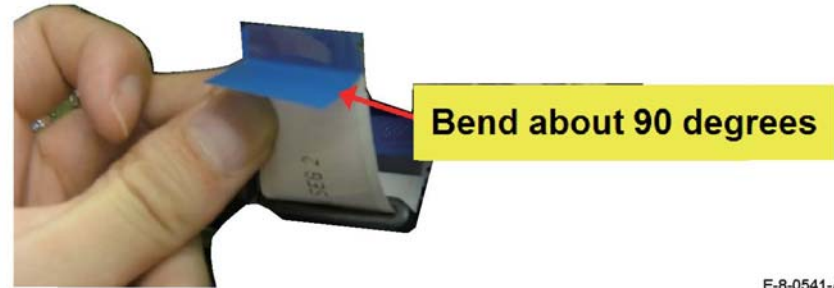
E-8-0541-A

1. Insert the FFC cable through the core and then bend the knob portion about 90 degrees, [Figure 3](#).

Figure 3 FFC cable installation

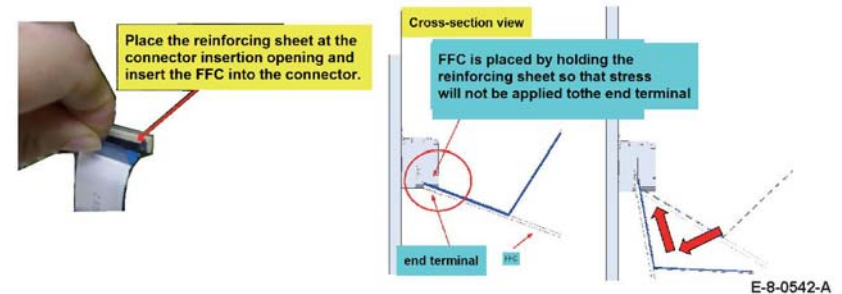
Figure 4 FFC cable installation

2. Place the reinforcing sheet, blue, at the insertion opening of the connector and insert it into the connector, [Figure 4](#).

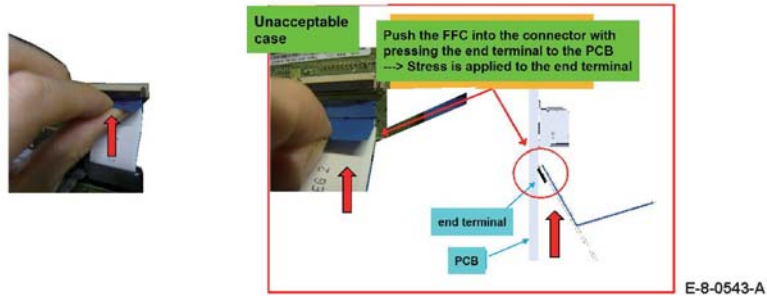
**Figure 5 FFC cable in home position**

3. Push the FFC cable into the connector until a clicking sound is heard, [Figure 5](#).

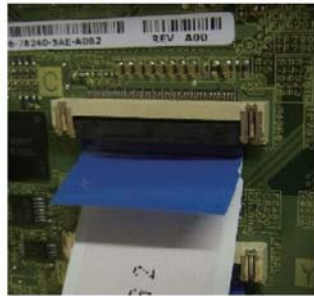
**Figure 6 FFC cable installation**

4. Check the final FFC cable installation, [Figure 6](#).

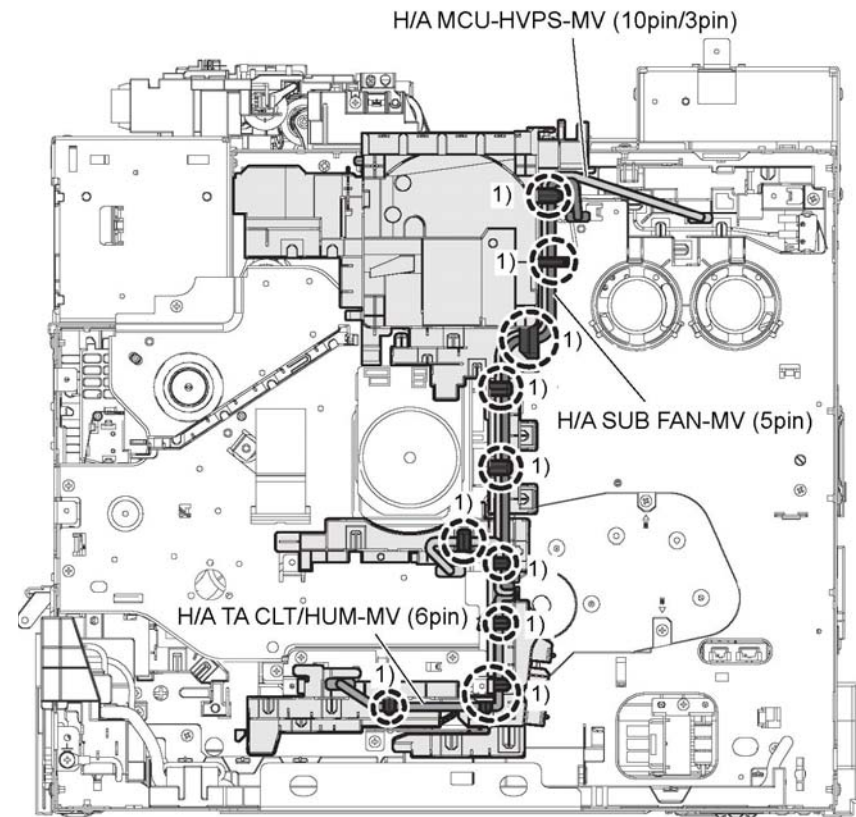
Figure 1 Harness assembly 1 removal

1. Remove the following harness assemblies from the main duct fan and MCU guide harness, [Figure 1](#):
  - MCU-HVPS-MV harness assembly.
  - Turn around clutch/humidity-MV harness assembly.
  - Sub fan-MV harness assembly.
