# VersaLink® B600/B610 Printer and B605/B615 Multifunction Printer Service Manual

Xerox® VersaLink® B600 Family MFP Service Manual

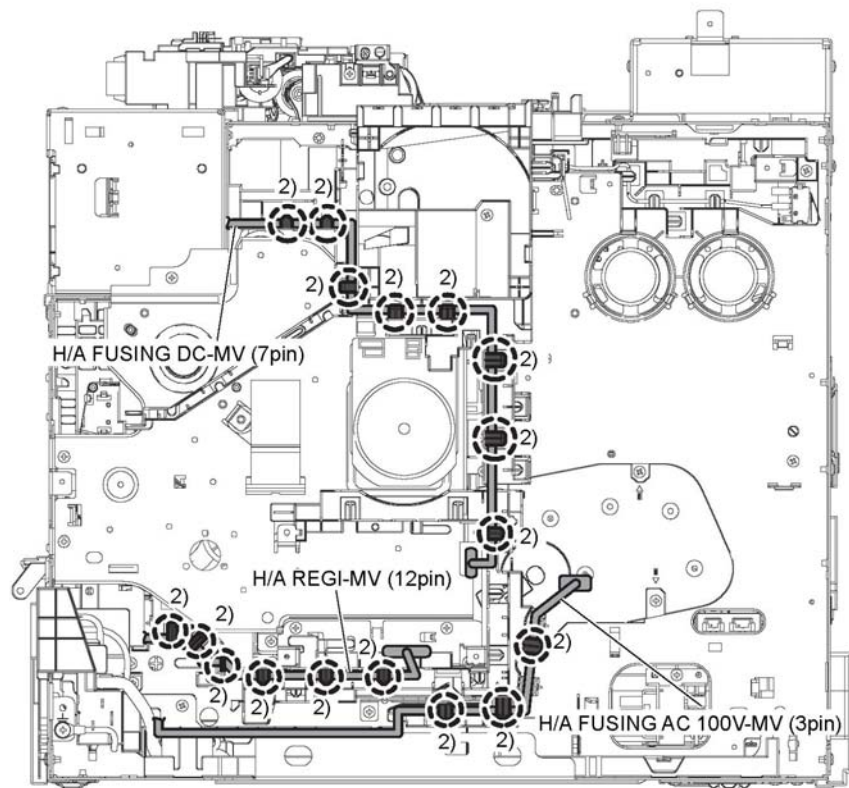
**Figure 2 Harness assembly 3 removal**

2. Release the following harness assemblies from the main fan duct and MCU guide harness, [Figure 2](#):
  - DC-MV fusing harness assembly.
  - 110V fusing harness assembly.
  - Registration-MV harness assembly.

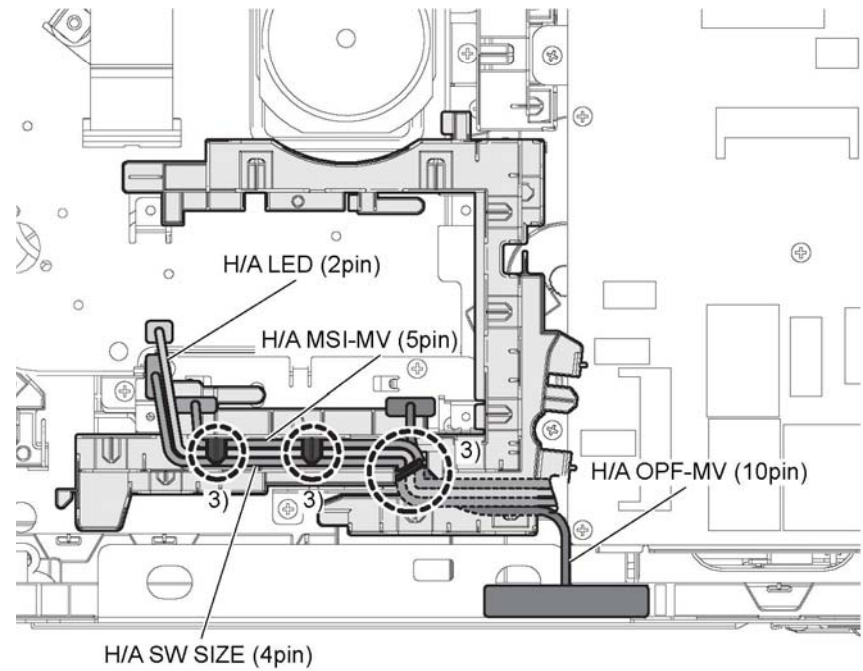
**Figure 3 Main duct fan and MCU guide harness**

3. Remove the following harness assemblies from the main fan duct, [Figure 3](#):
  - Optional feeder-MV harness assembly.
  - Size switch harness assembly.
  - MSI-MV harness assembly.
  - LED harness assembly.

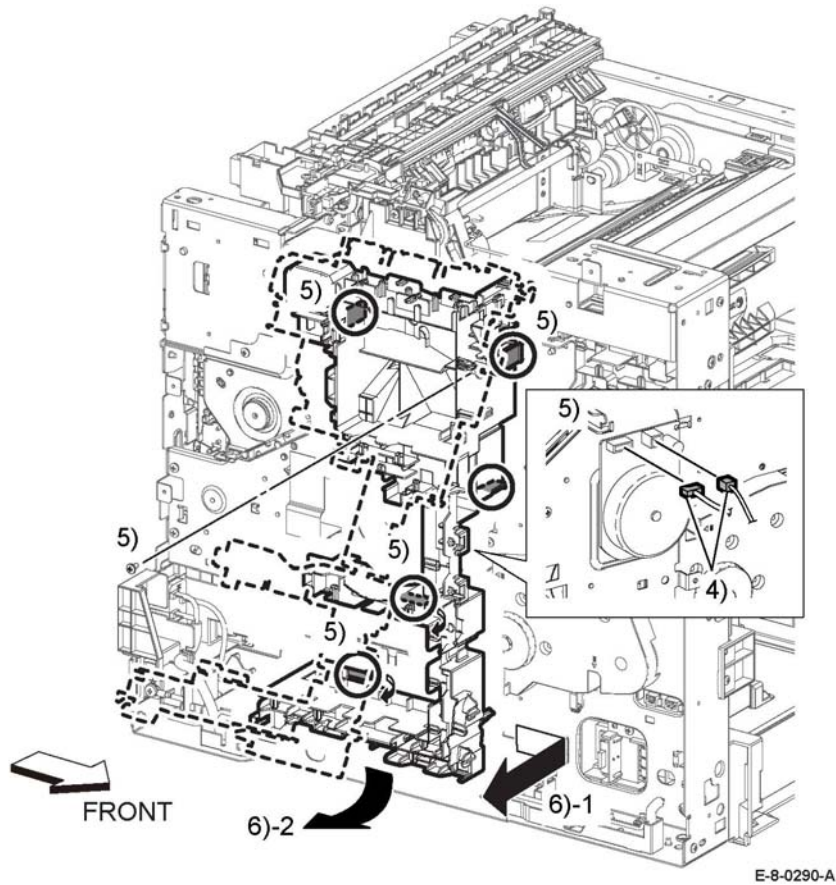
Figure 4 Harness assembly 2 removal

4. Disconnect connectors [P/J571](#), [P/J572](#), [Figure 4](#).
5. Perform the items that follow, [Figure 4](#):
  - Release the hooks.
  - Remove one screw (SM18).
  - Remove the main duct fan and MCU guide harness.
6. Remove in the direction shown, [Figure 4](#).

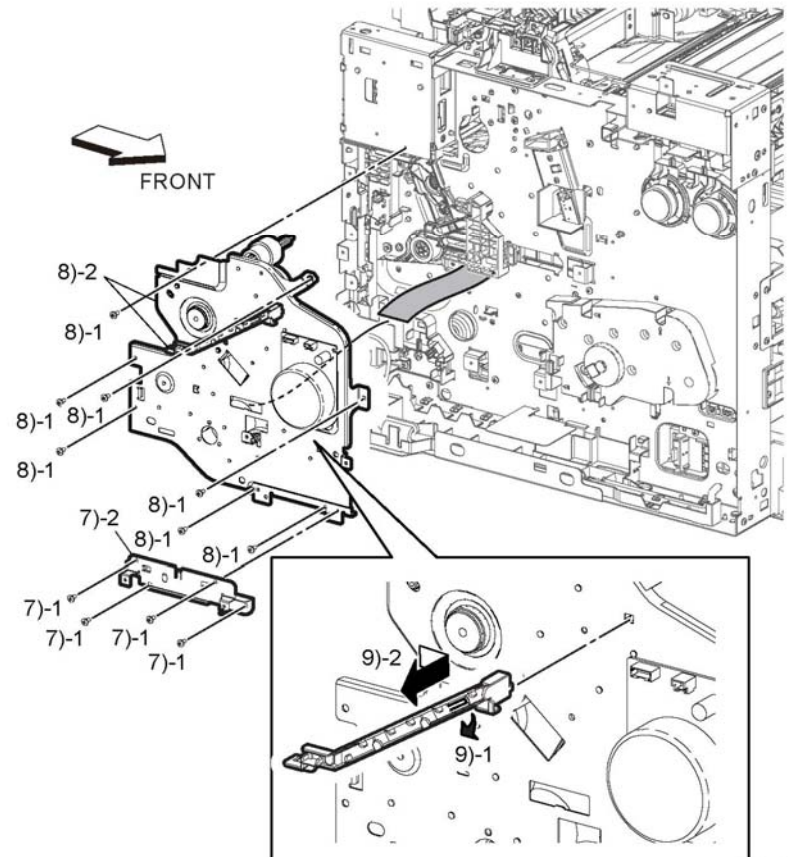
Figure 5 Rear interlock guide harness assembly removal

- 9-1 Release the hook.

9-2 Remove the rear interlock guide harness assembly from the main drive assembly.

7. Remove the items that follow, Figure 5:

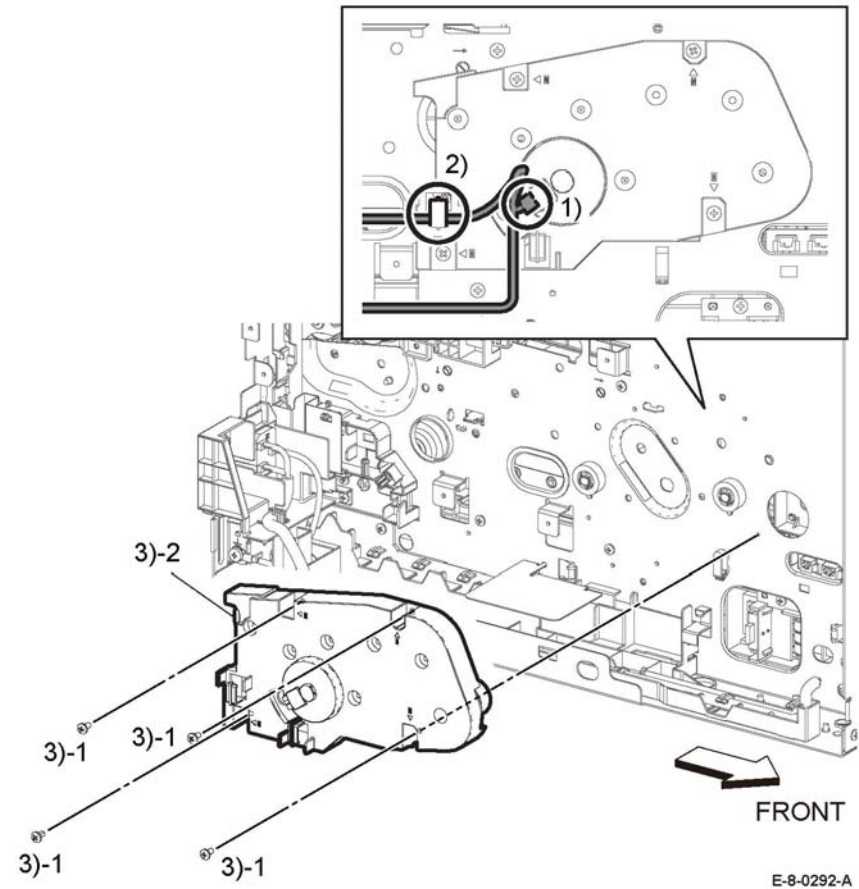
Figure 1 MSI drive assembly

1. Disconnect connector [P/J146](#), [Figure 1](#).
2. Release the MSI drive assembly harness from the harness guide, [Figure 1](#).
3. Remove the items that follow, [Figure 1](#):
  - 3.1 Four screws.
  - 3.2 MSI drive assembly

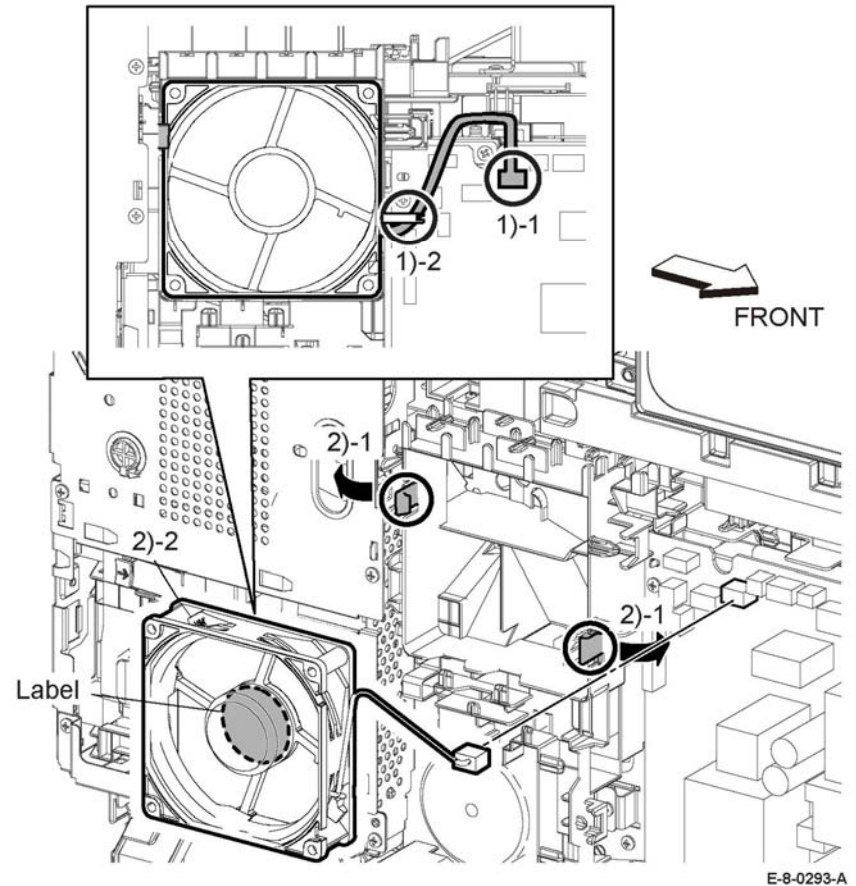
Figure 1 Remove the main fan

1. Disconnect connector, P/J289, Figure 1.
2. Release the two hooks attaching the main fan to the main fan duct and remove the main fan, Figure 1.

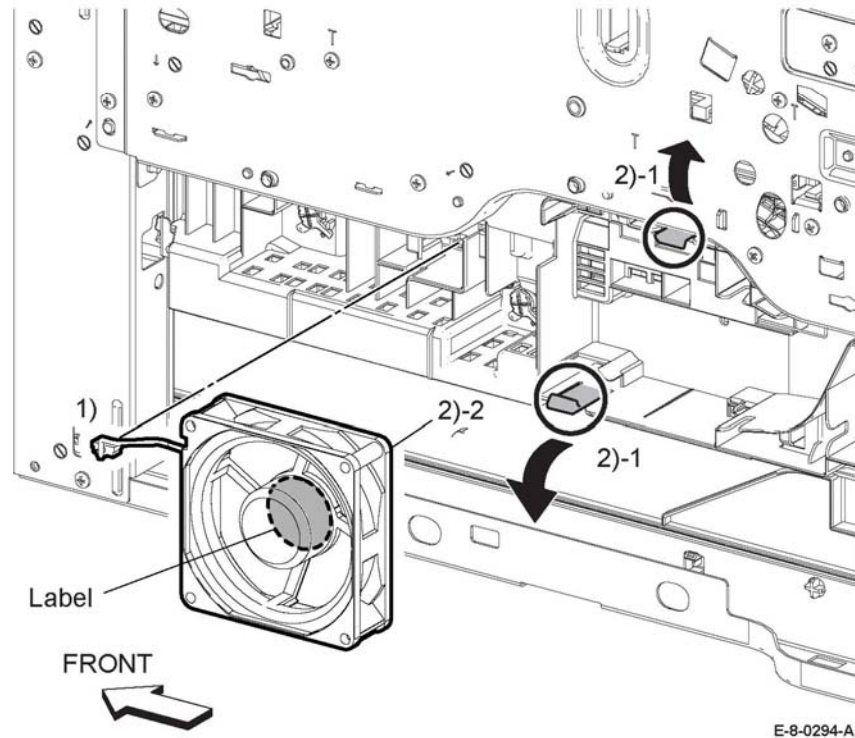
Figure 1 Remove the sub fan

1. Disconnect connector, [P/J294](#), [Figure 1](#).
2. Release the two hooks attaching the main fan to the main fan duct and remove the main fan, [Figure 1](#).

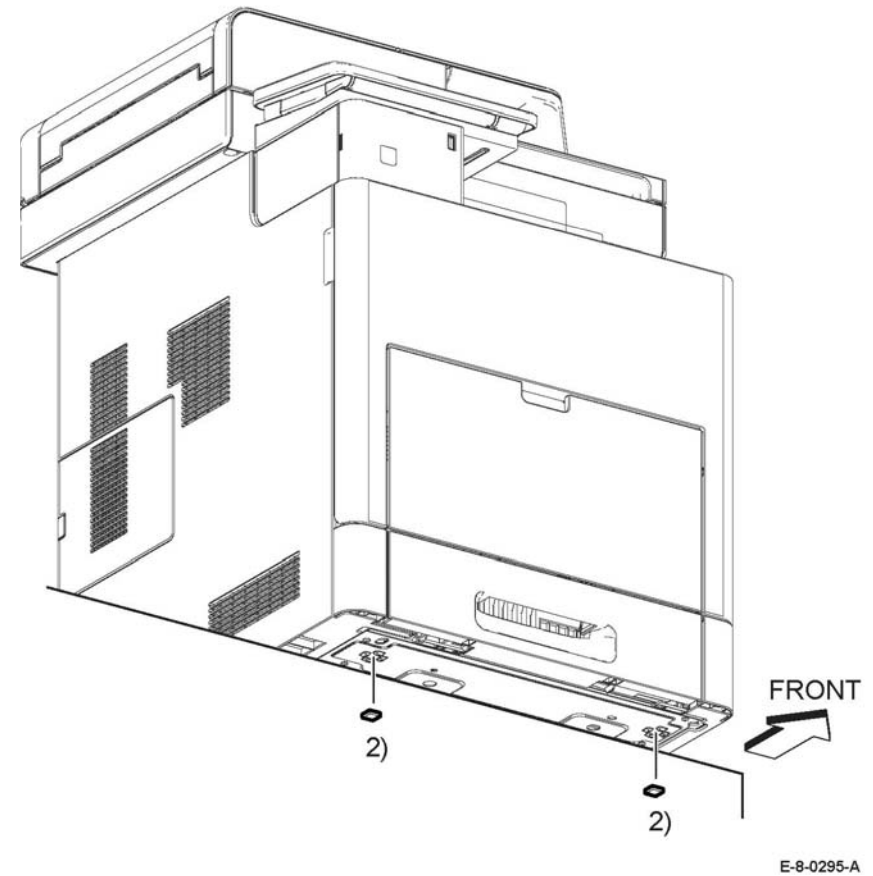
Figure 1 Install new front bottom feet

1. Position the front of the printer to overhang the edge of the workbench.
2. Install the new front two feet, [Figure 1](#).

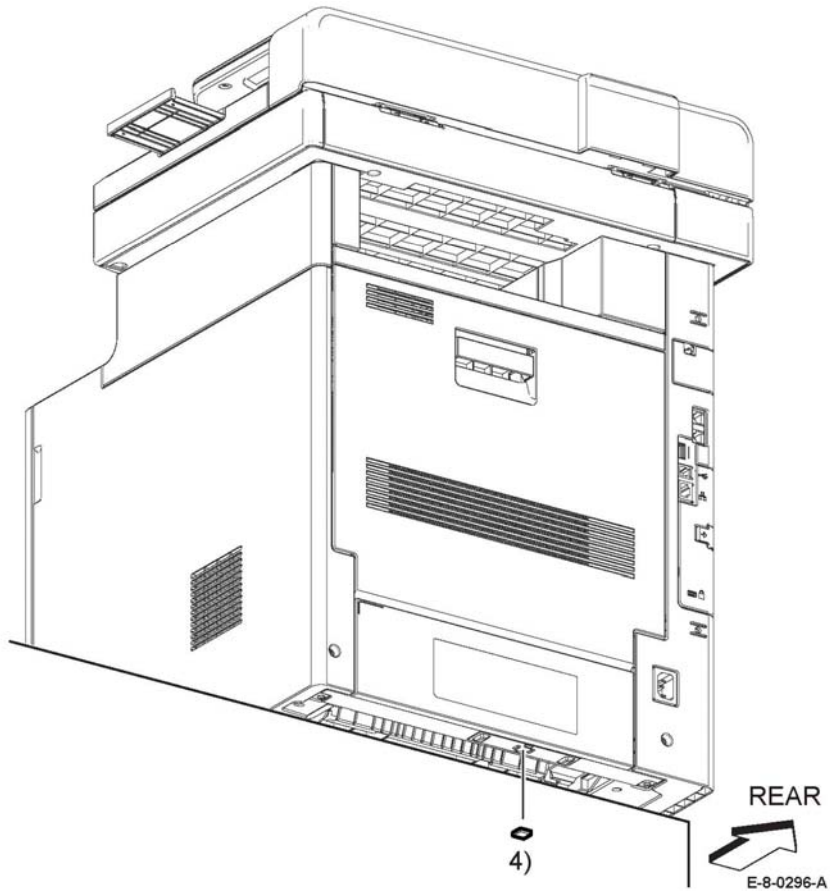
Figure 2 Install new rear bottom foot

3. Position the back of the printer to overhang the edge of the workbench.
4. Install a new rear bottom foot, [Figure 2](#).

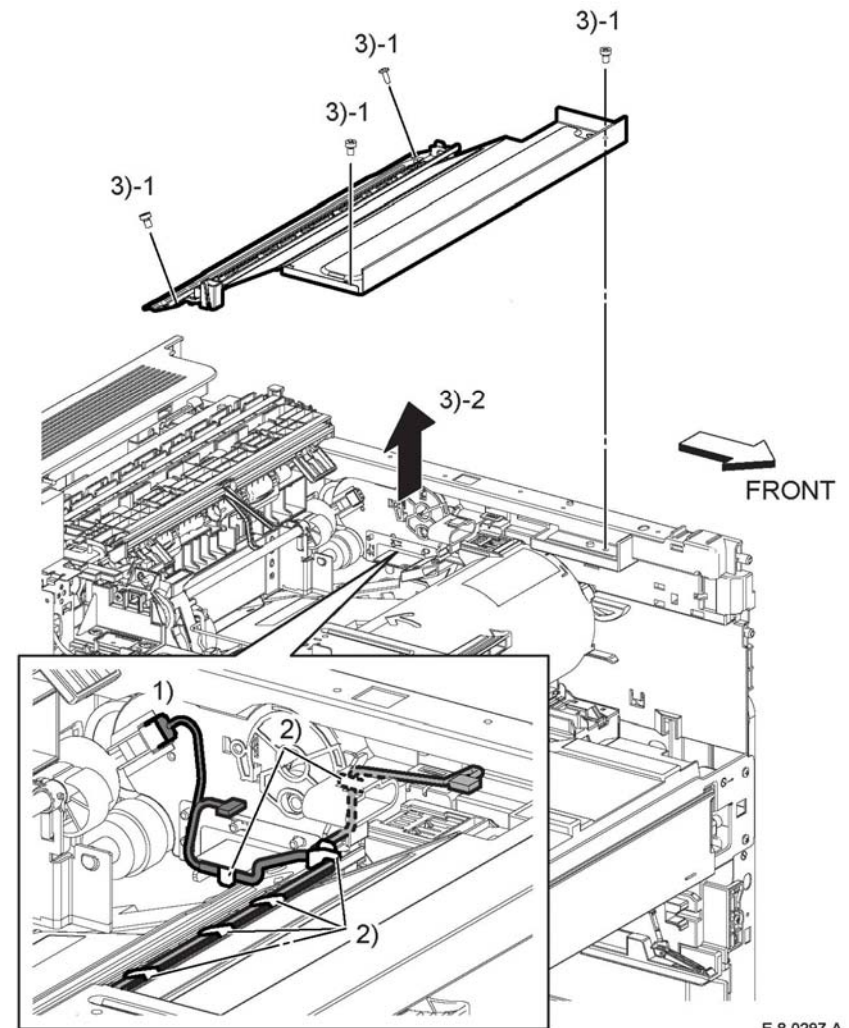
Figure 1 Top MONO frame

1. Disconnect connector [P/J171](#), [Figure 1](#).
2. Release the dispenser/environmental-MV and CRUM-MV harness assemblies, [Figure 1](#).
3. Remove the items that follow, [Figure 1](#):
  - 3-1 One (ST20) and three (SM3) screws.
  - 3-2 Top MONO frame.

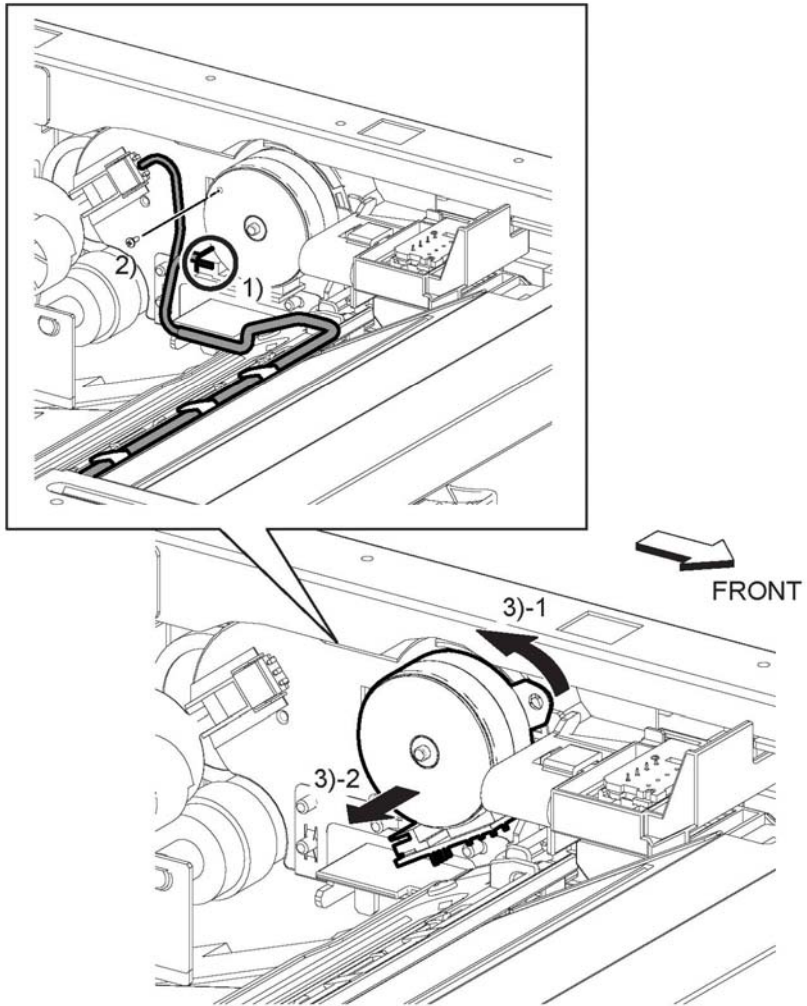
Figure 1 Dispenser/environmental motor

1. Disconnect connector [P/J122](#), [Figure 1](#).
2. Remove one screw (ST20), [Figure 1](#).
3. Perform the items that follow, [Figure 1](#):
  - 3-1 Rotate the dispenser/environmental motor.
  - 3-2 Remove the environmental motor.

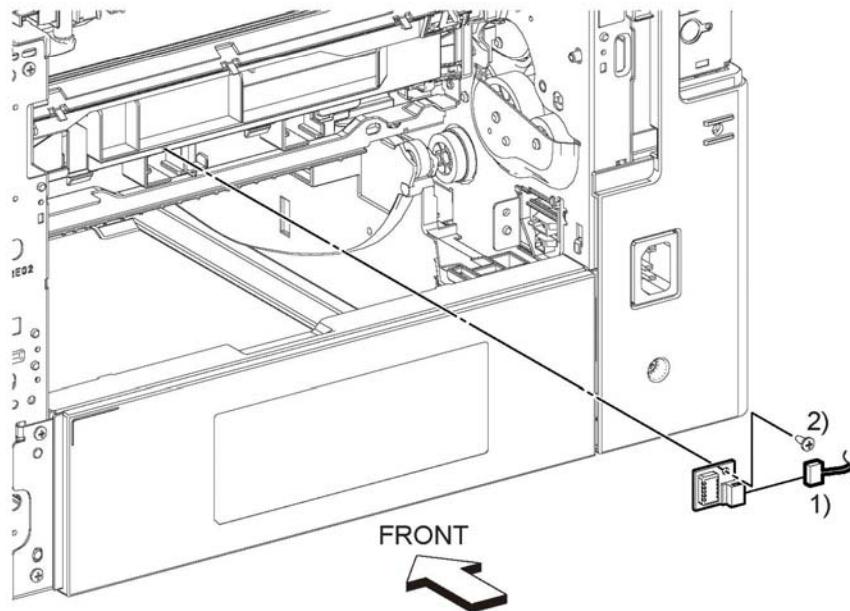
Figure 1 Humidity and temperature sensor

1. Disconnect connector [P/J145](#), [Figure 1](#).
2. Remove one screw (ST20) and the humidity and temperature sensor, [Figure 1](#).

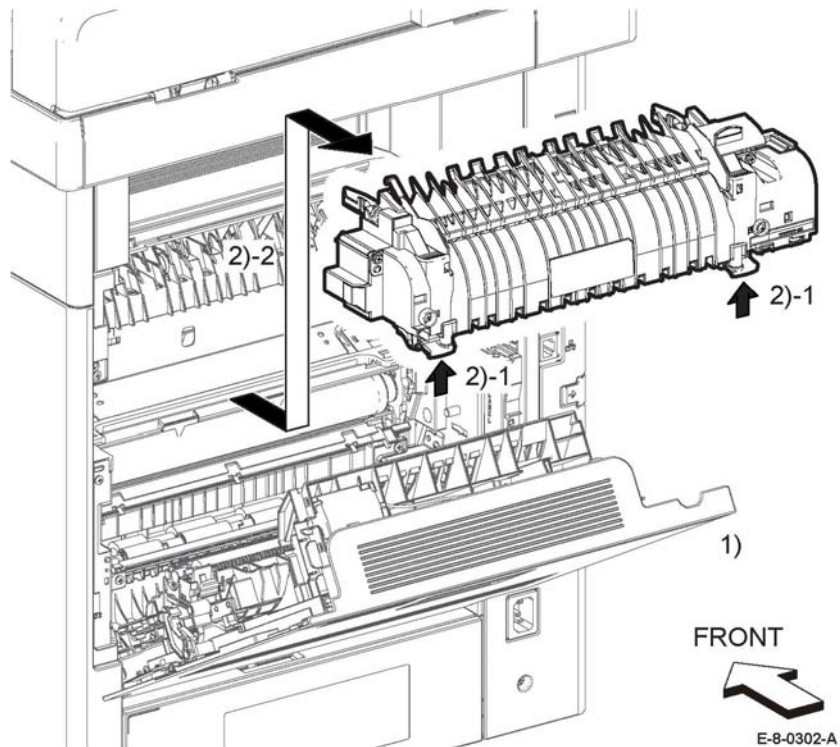
Figure 1 Fuser Assembly

1. Open the rear cover assembly, REP 19.18, MFP, MFP tall REP 19.25, SFP.
2. Remove the items that follow, Figure 1:
  - 2-1 Lift up the tabs.
  - 2-2 Left the fusing assembly out of the frame as shown.

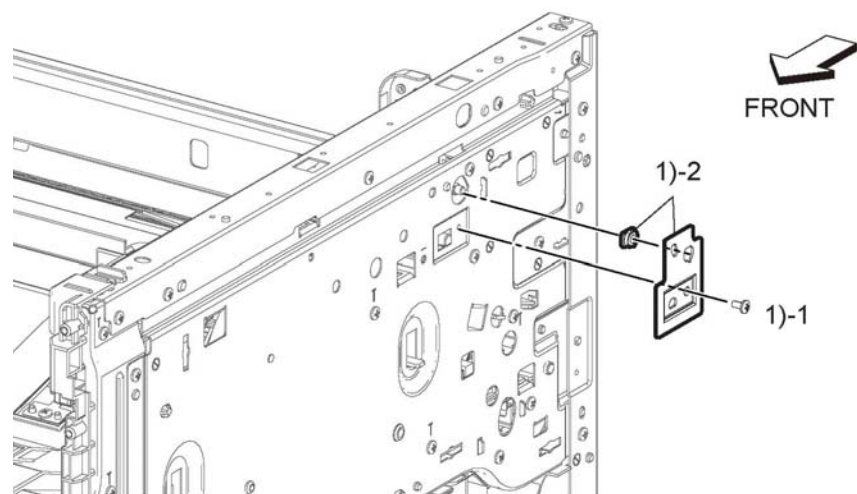
Figure 1 Retract nip bracket

1-2 Retract nip bracket with the bearing.

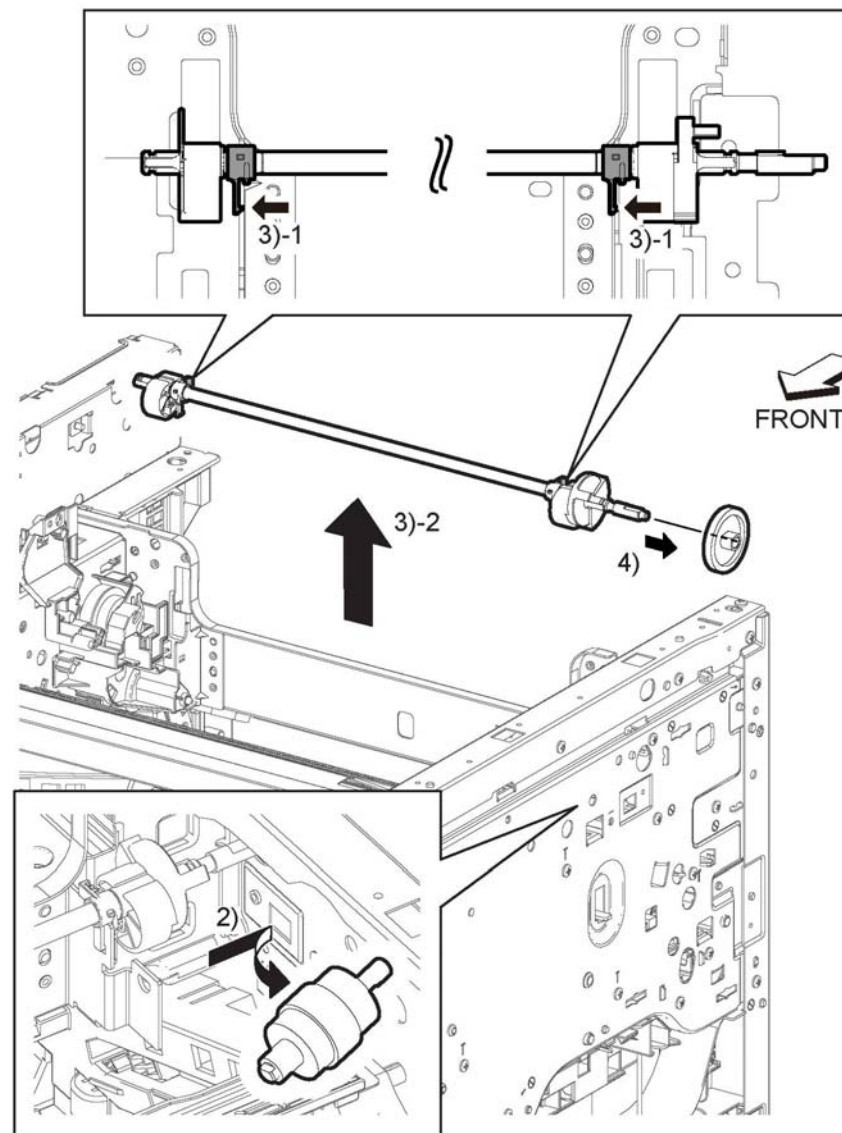
Figure 2 Retraction shaft and gear

2. Remove the retract damper shaft, Figure 2.
3. Perform the items that follow, Figure 2.
  - 3-1 Release the levers.
  - 3-2 Remove the retraction shaft.
4. Remove the shaft retraction gear, Figure 2.

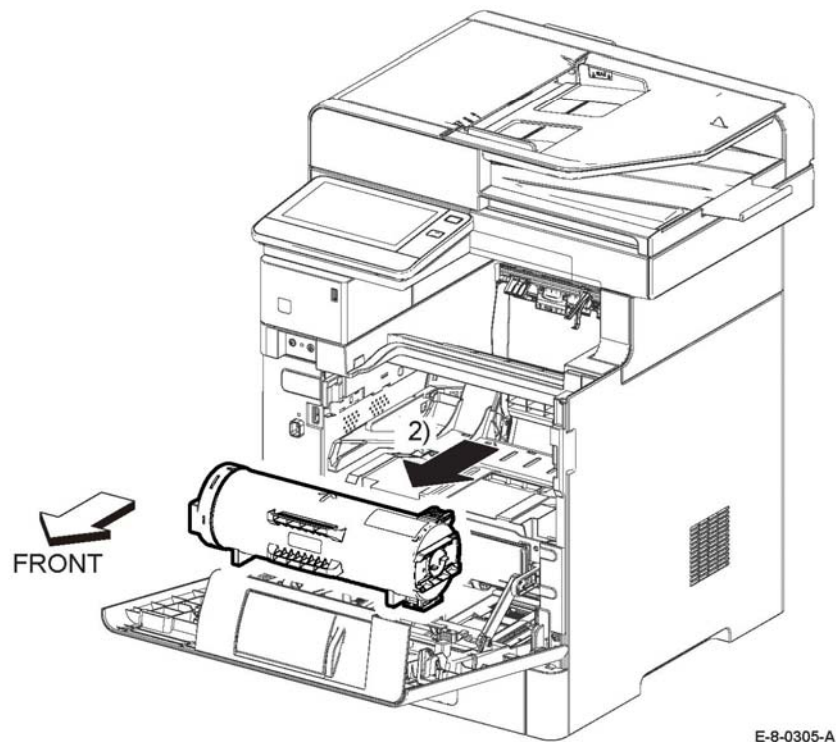
Figure 1 Remove toner cartridge

1. Open the front cover assembly, [Figure 1](#).
2. Remove the toner cartridge, [Figure 1](#).

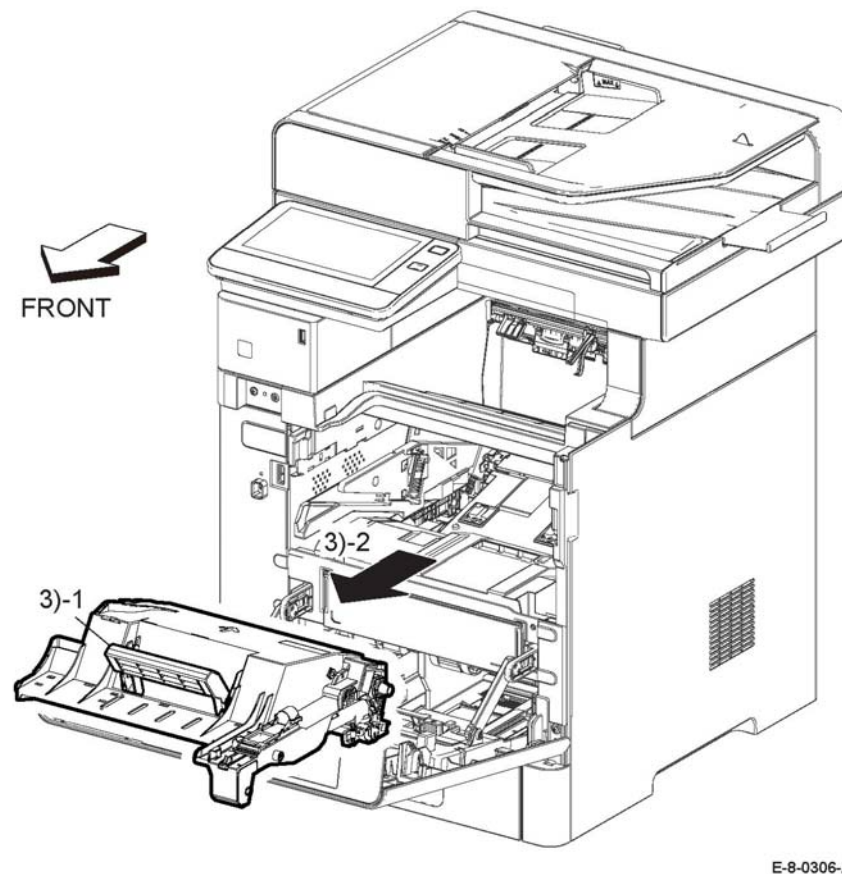
Figure 2 Remove the CRU xerographic developer assembly

3. Perform the items that follow, [Figure 2](#).
  - 3-1 Grasp the handle of the CRU xerographic developer assembly.
  - 3-2 Pull the CRU xerographic developer assembly out of the printer.

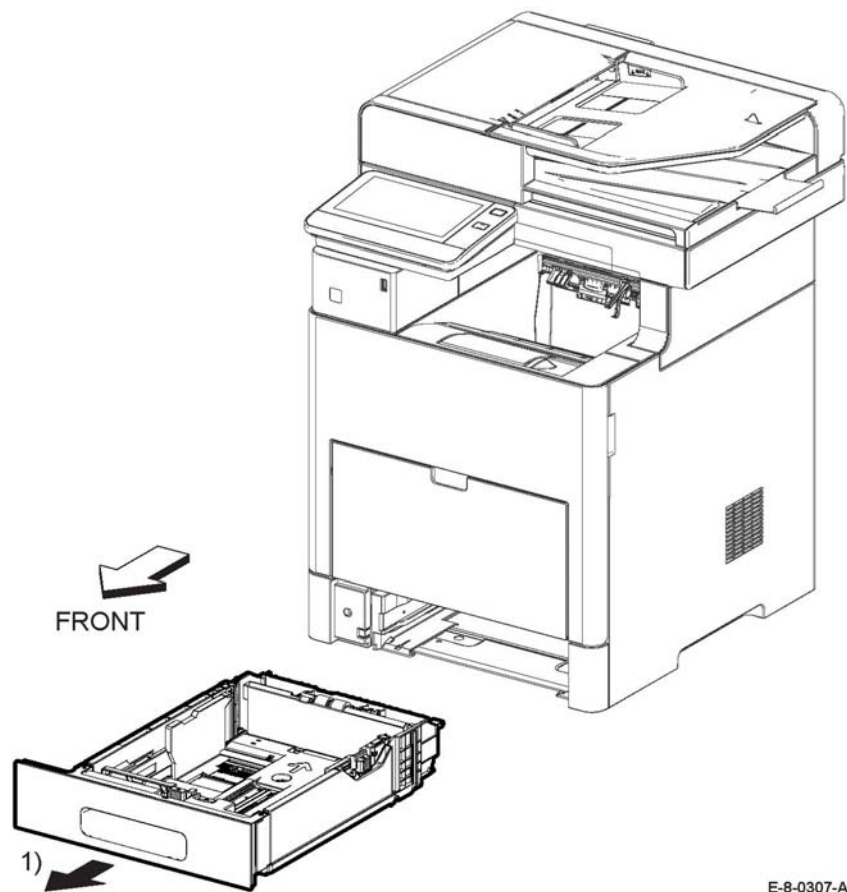
Figure 1 Feed tray assembly removal

1. Remove the feed tray assembly from the printer, [Figure 1](#).

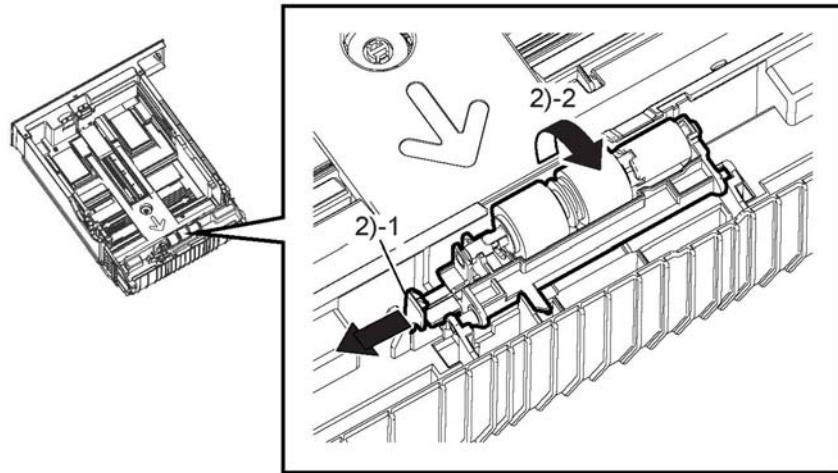
Figure 1 Remove the CST separator holder.

1. Remove the 550 feed tray assembly, [REP 9.1](#).
2. Perform the items that follow, [Figure 1](#):
  - 2-1 Release the hook.
  - 2-2 Turn up and remove the CST separator holder assembly.

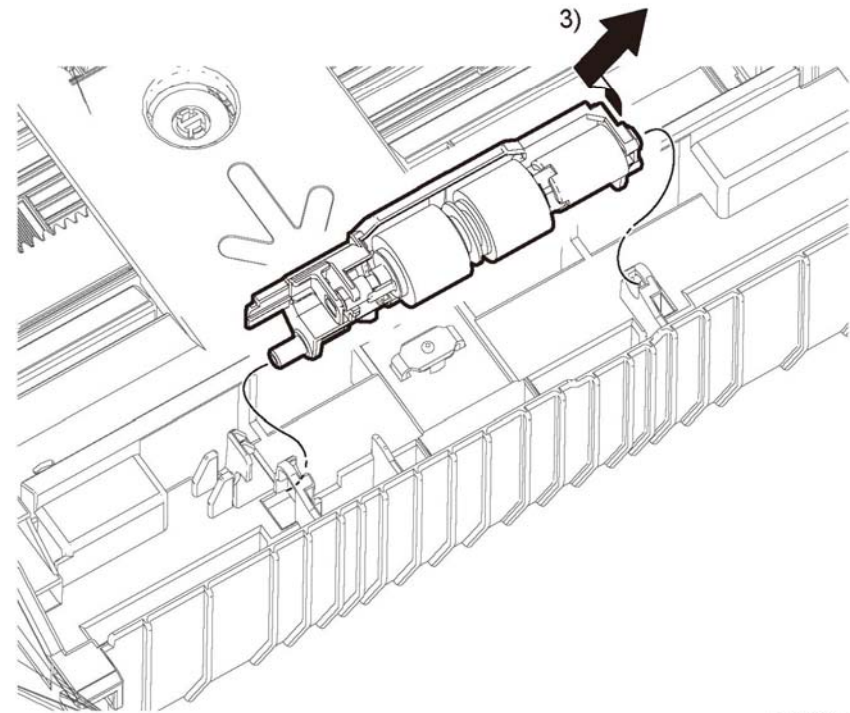
Figure 2 Remove the CST separator holder

3. Remove the CST separator holder assembly, [Figure 2](#).

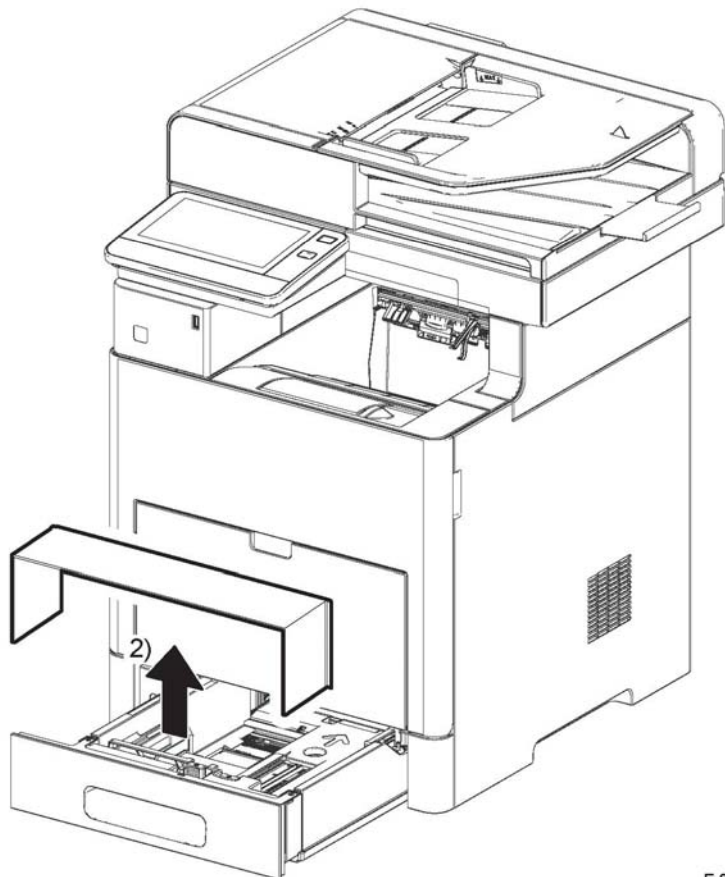
Figure 1 Remove the legal paper tray dust cover

1. Pull out the 550 cassette assembly, [Figure 1](#).
2. Release the latches that hold the legal paper tray dust cover to the cassette, and remove the cover, [Figure 1](#).

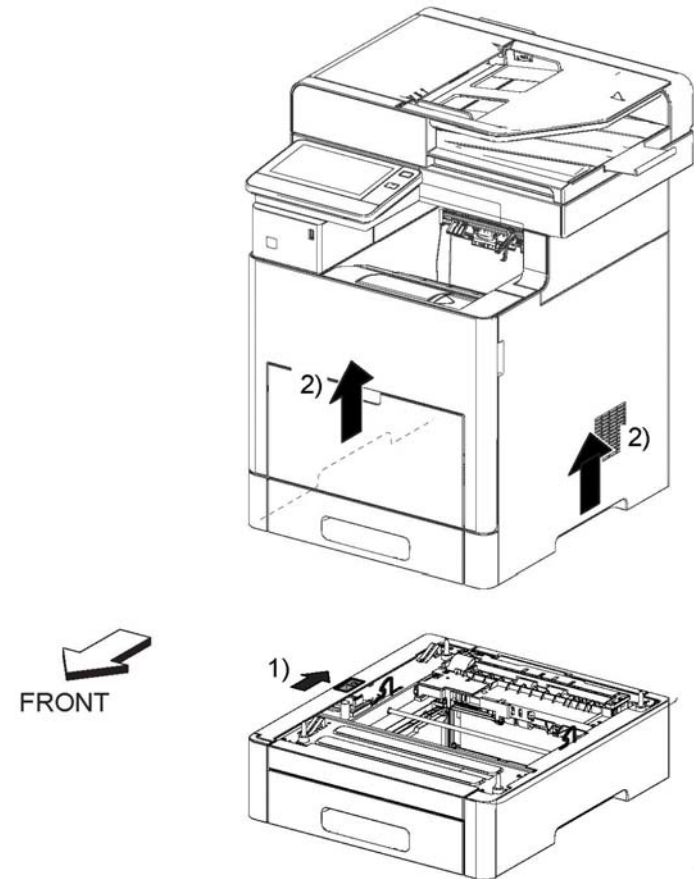
Figure 1 Remove the 550 option feeder assembly

2. Hold the recessed areas on both sides and raise the printer to separate it from the 550 option feeder assembly, [Figure 1](#). Refer to [GP 7](#) for machine configurations.

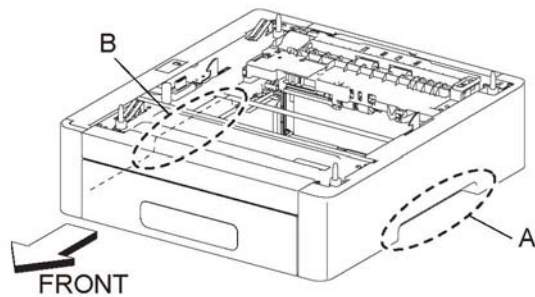
Figure 1 Locations to hold the 550 option feeder

1. Hold the 550 option feeder assembly in areas A and B, then turn over the feeder, [Figure 1](#).

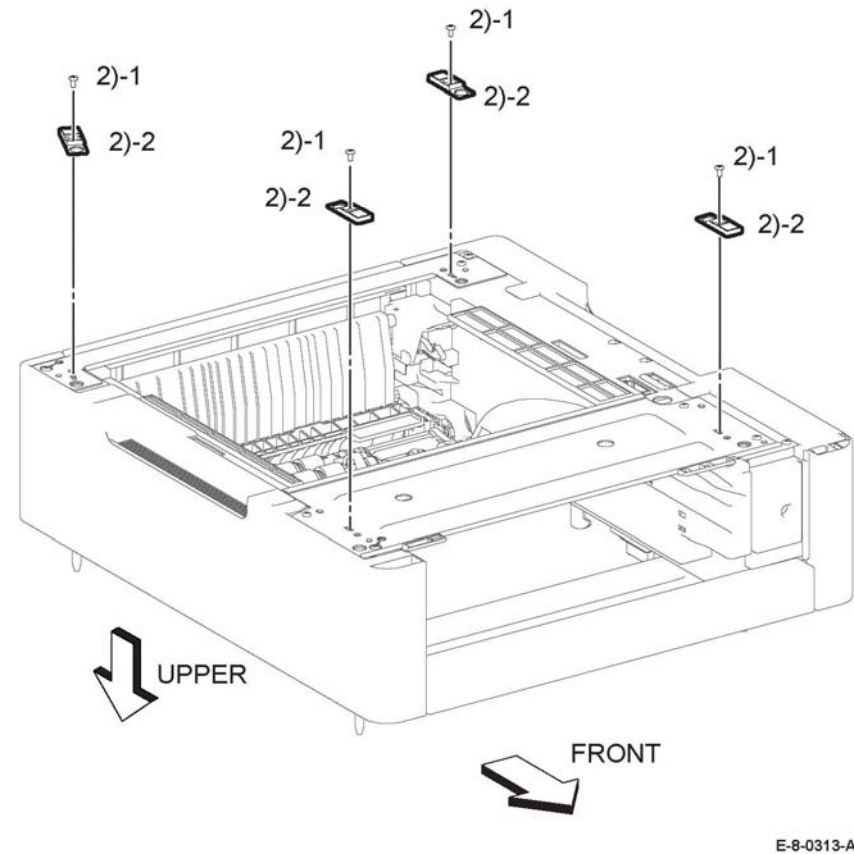
Figure 2 Remove the 550 option feeder feet

2. Remove the items that follow, [Figure 2](#):
  - 2-1 Four screws (SM3).
  - 2-2 Four feet.

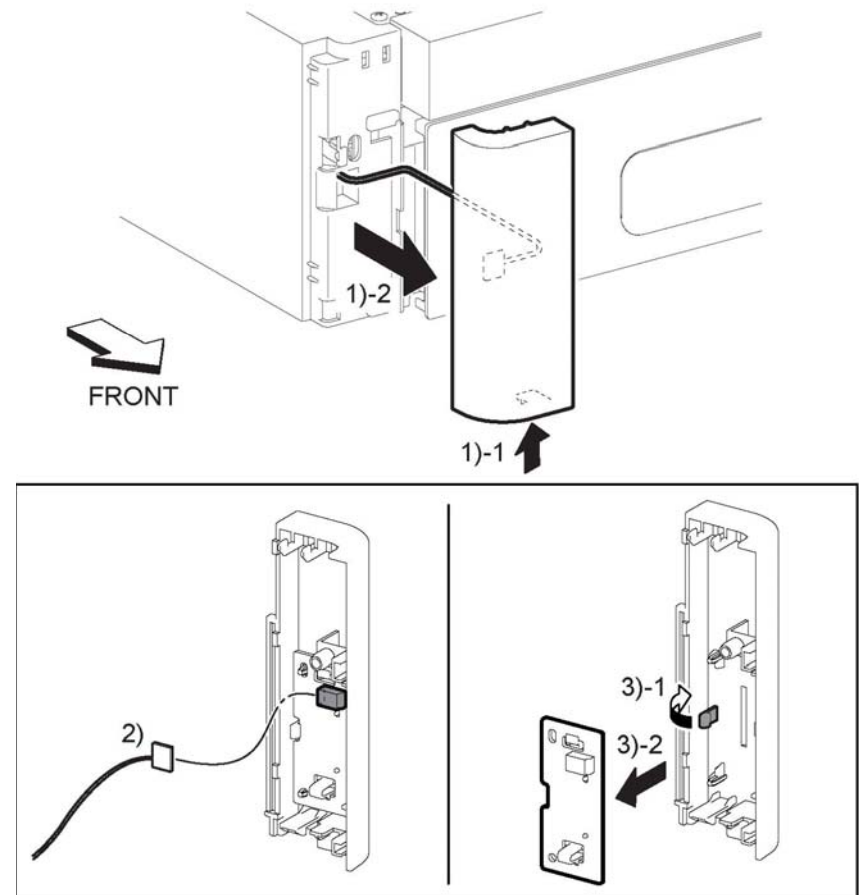
Figure 1 Remove the 550 option feeder left front cover

1. Perform the items that follow, [Figure 1](#):
  - 1-1 Press the hook to release the left front optional feed cover.
  - 1-2 Remove the left front optional feed cover.
2. Disconnect connector [P/J814](#) from the left front cover, [Figure 1](#).
3. Perform the items that follow, [Figure 1](#):
  - 3-1 Release the hook.
  - 3-2 Remove the LED shade tree PWB.

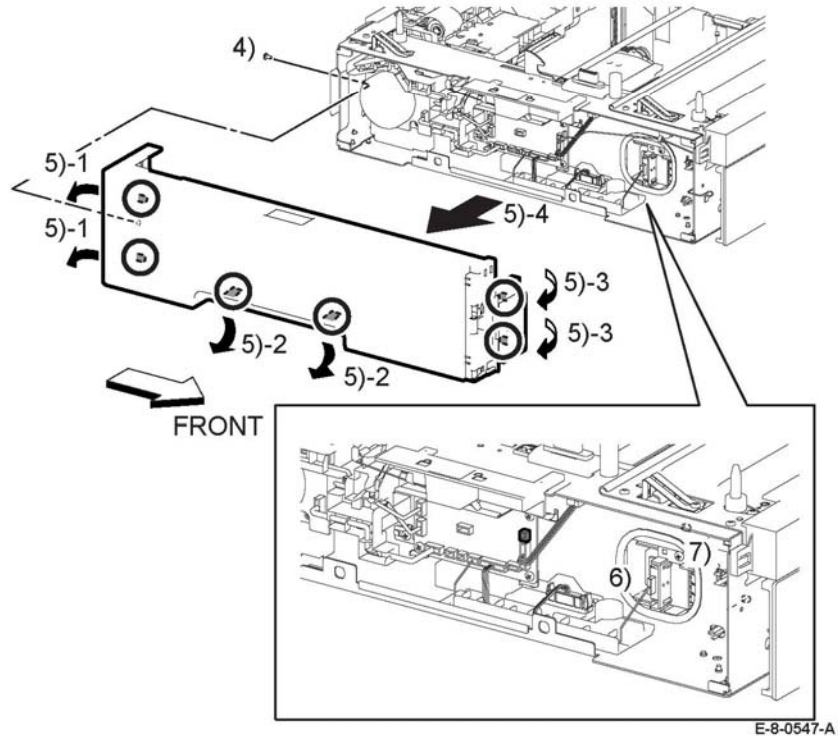
Figure 2 Remove left side cover and size switch assembly

4. Remove one screw (SM18) and the size switch assembly, [Figure 2](#).
5. Perform the items that follow, [Figure 2](#):
  - 5-1 Release two bosses.
  - 5-2 Release two hooks.
  - 5-3 Release two bosses.
  - 5-4 Remove the optional 550 feeder left side cover.

6. Disconnect connector P/J814, Figure 2.
7. Remove one screw and the size switch assembly, Figure 2.

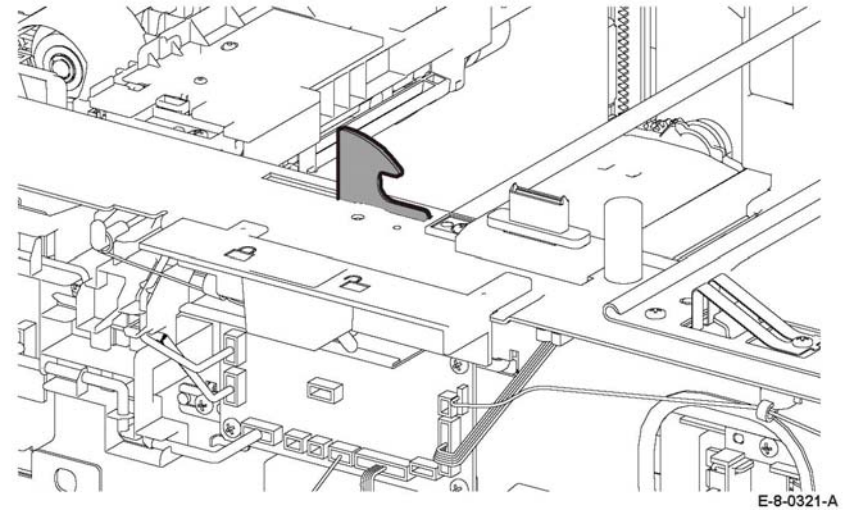
Figure 3 Place the option feeder lock into locked position

**NOTE:** Before installing the option feeder left side cover, set the option feeder lock assembly to the lock position, Figure 3.

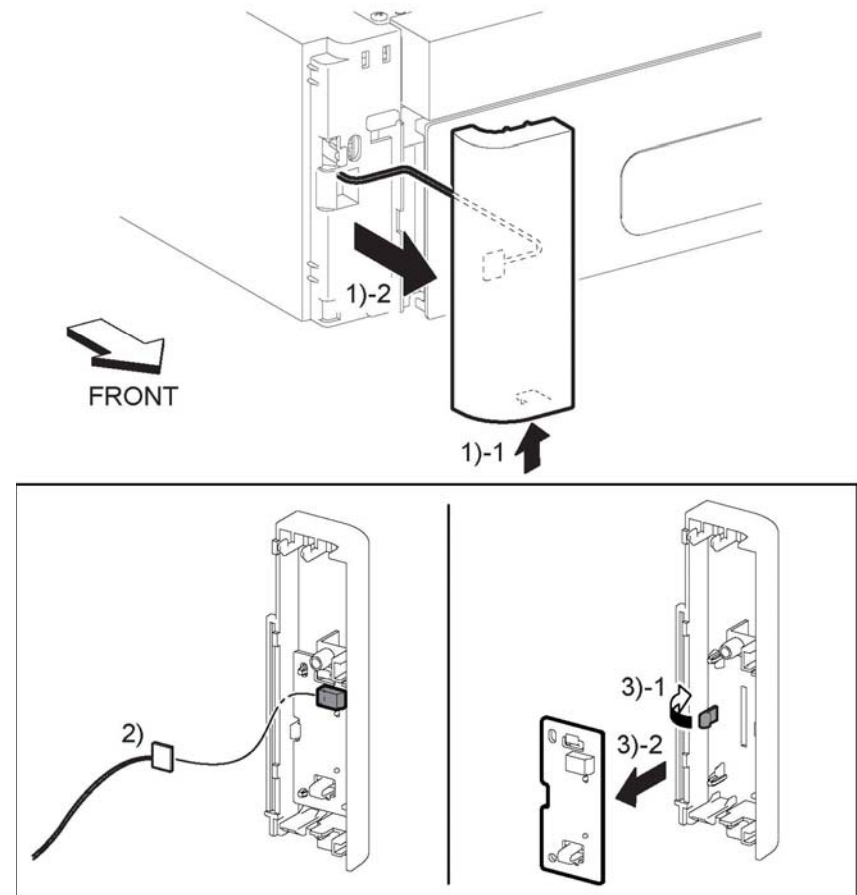
Figure 1 Remove the 550 option feeder left front cover

1. Perform the items that follow, [Figure 1](#):
  - 1-1 Push the hook
  - 1-2 Remove the left optional front cover.
2. Disconnect connector [P/J814](#) from the left front cover.
3. Perform the items that follow, [Figure 1](#).
  - 3-1 Release the hook.
  - 3-2 Remove the shade tray cover and tray LED assembly.

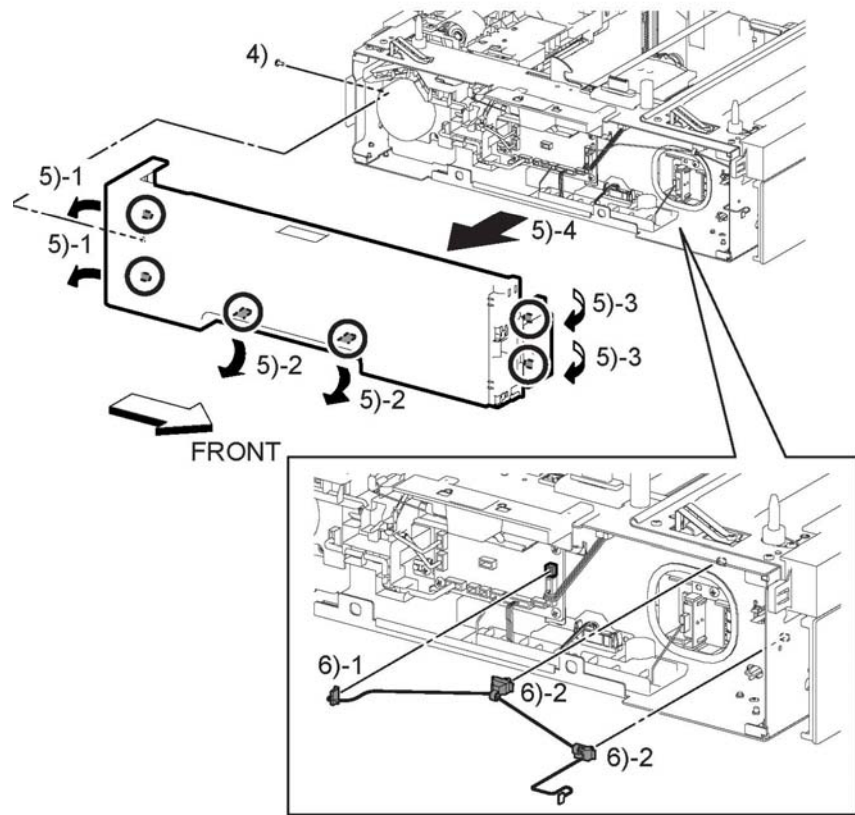
Figure 2 Remove the LED harness Assembly

4. Remove one screw (SM18) from the 550 option feeder left side cover.
5. Perform the items that follow, [Figure 2](#):
  - 5-1 Release two bosses at the rear side.
  - 5-2 Release two hooks at the bottom
  - 5-3 Release two bosses at the front side and the left side optional 550 feeder cover.
6. Perform the items that follow, [Figure 2](#):

- 6-1 Disconnect connector P/J813.
- 6-2 Remove two ties and the LED harness assembly.

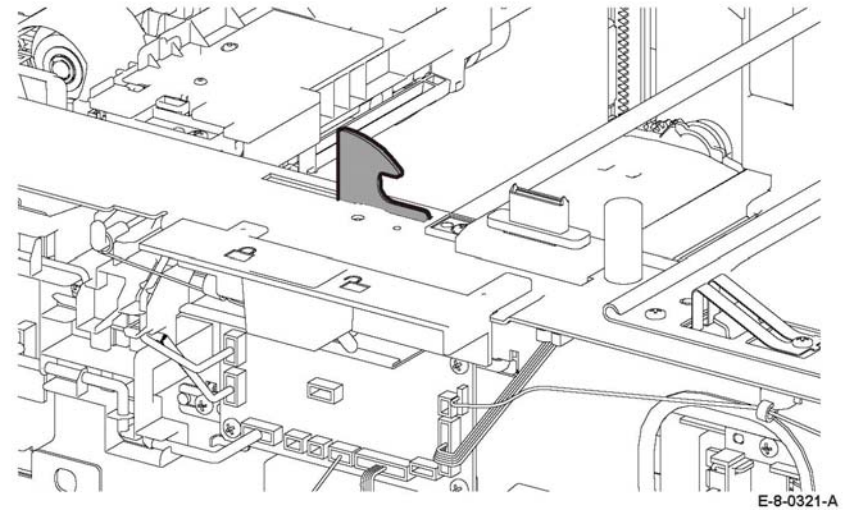
Figure 3 Place the option feeder lock into locked position

**NOTE:** Before installing the option feeder left side cover, set the option feeder lock assembly to the lock position as shown in Figure 3.

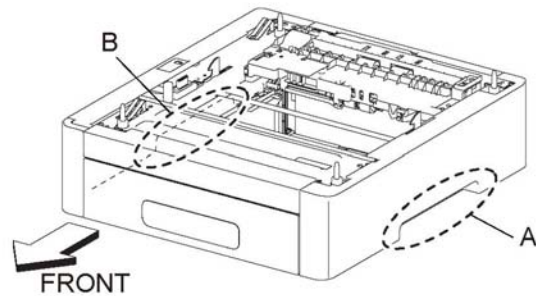
Figure 1 holding positions

1. Hold positions A and B and turn the optional 550 feeder upside down, [Figure 1](#).

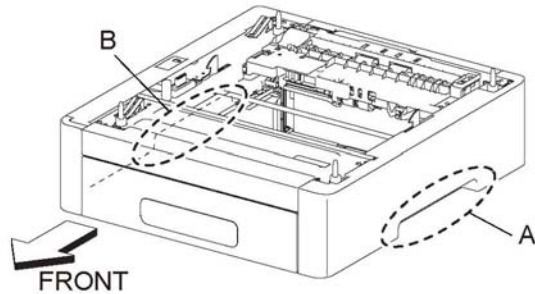
Figure 1 Locations to hold the 550 option feeder

1. Hold the 550 option feeder assembly using positions A and B, then turn the feeder up side down, [Figure 1](#).

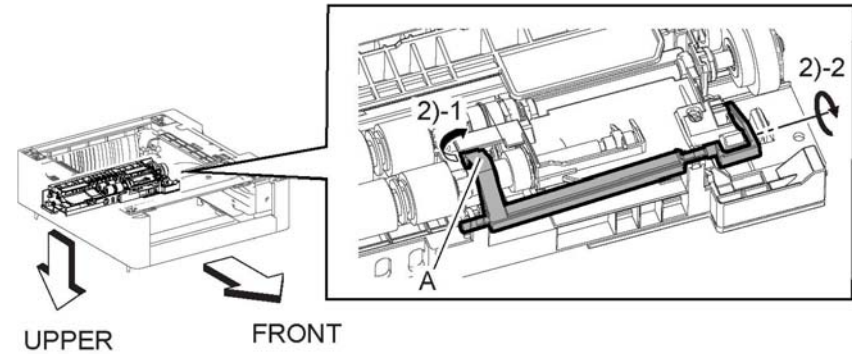
Figure 2 Release the no paper actuator

2. Perform the items that follow, [Figure 2](#):
  - 2.1 Release position A.
  - 2.2 Rotate in the direction of the arrow

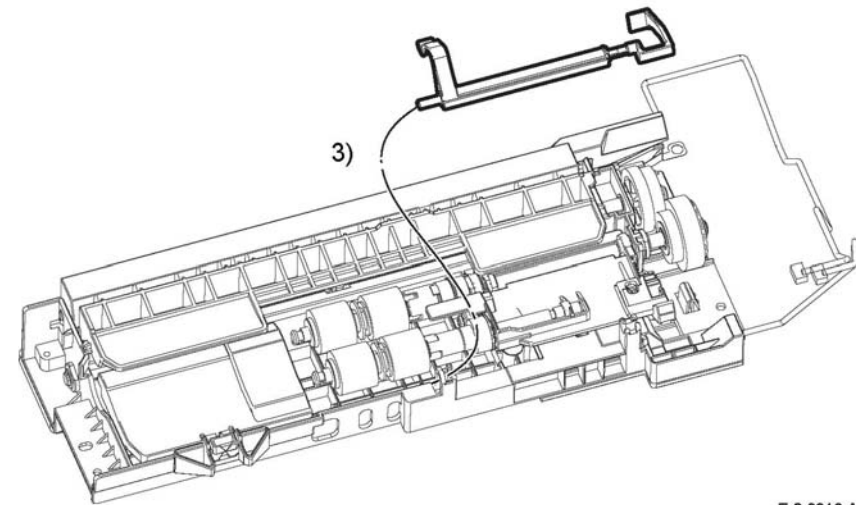
Figure 3 Remove the no paper actuator

3. Remove the no paper actuator, [Figure 3](#).

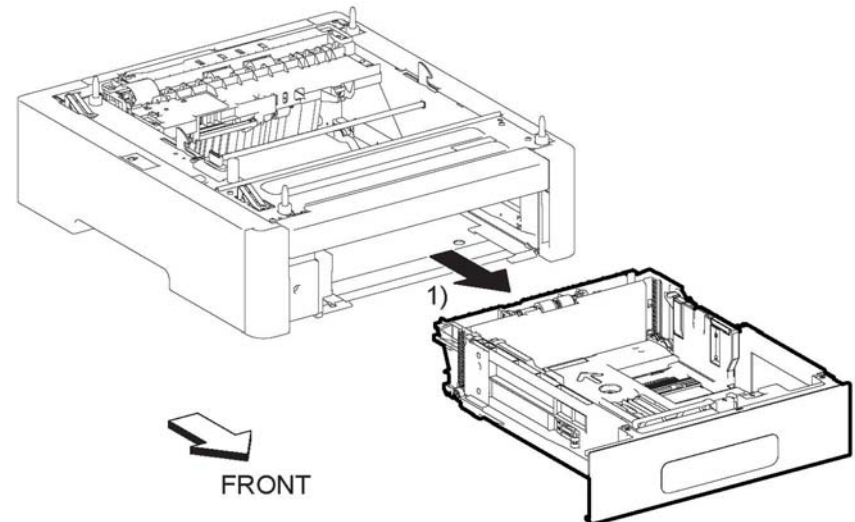
Figure 1 Remove the 550 option cassette assembly

1. Remove the 550 option cassette assembly from the 550 option feeder assembly, [Figure 1](#).
