# VersaLink® B600/B610 Printer and B605/B615 Multifunction Printer Service Manual

Xerox® VersaLink® B600 Family MFP Service Manual

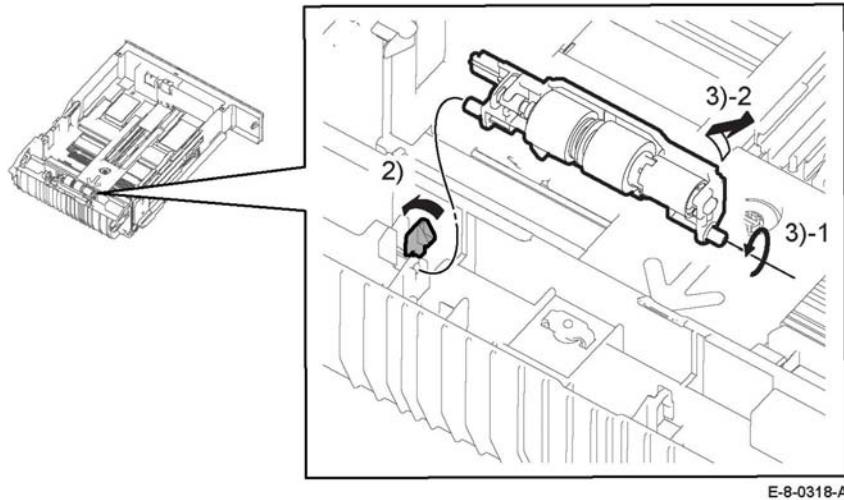
Figure 1 Remove the cassette separator holder assembly

1. Remove the 550 option cassette assembly, [REP 10.8](#).
2. Release the hook on the holder, [Figure 1](#).
3. Perform the items that follow, [Figure 1](#):
  - 3-1 Rotate the cassette separator holder assembly.
  - 3-2 Remove the cassette separator holder assembly.

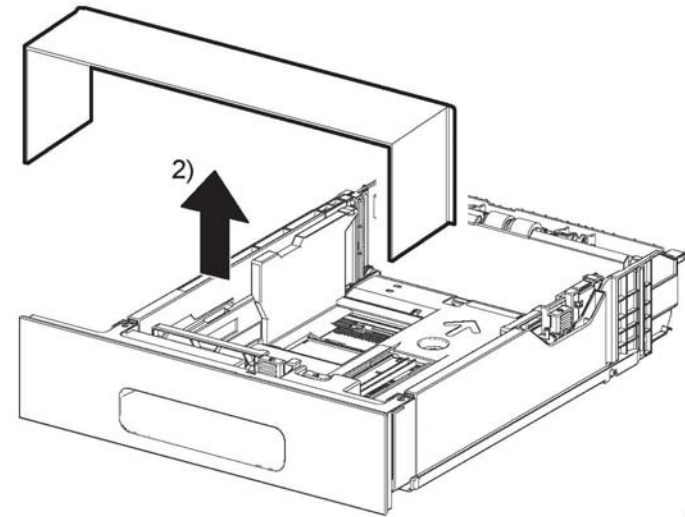
Figure 1 Remove the legal paper tray cover

1. Remove the 550 option cassette assembly, [REP 10.8](#).
2. Remove the legal paper tray cover, [Figure 1](#).

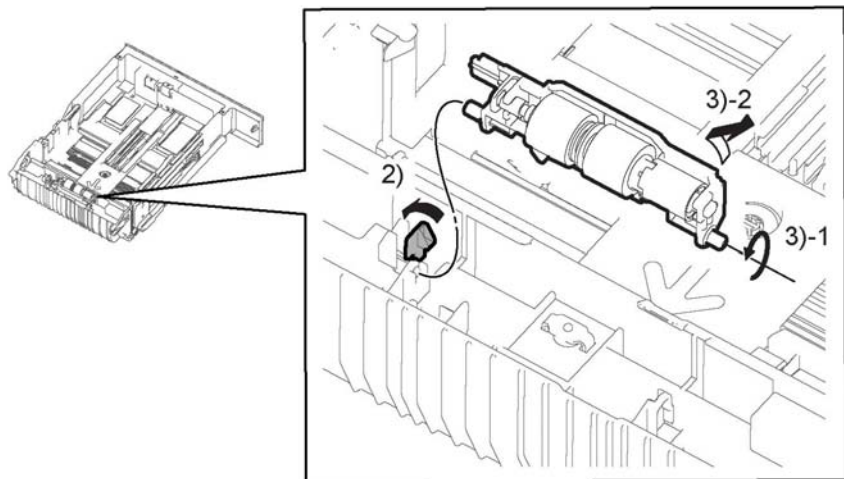
Figure 1 Remove the cassette separator holder assembly

1. Remove the 550 option cassette assembly, [REP 10.8](#).
2. Release the hook on the holder, [Figure 1](#).
3. Perform the items that follow, [Figure 1](#):
  - 3-1 Rotate the cassette separator holder assembly.
  - 3-2 Remove the cassette separator holder assembly.

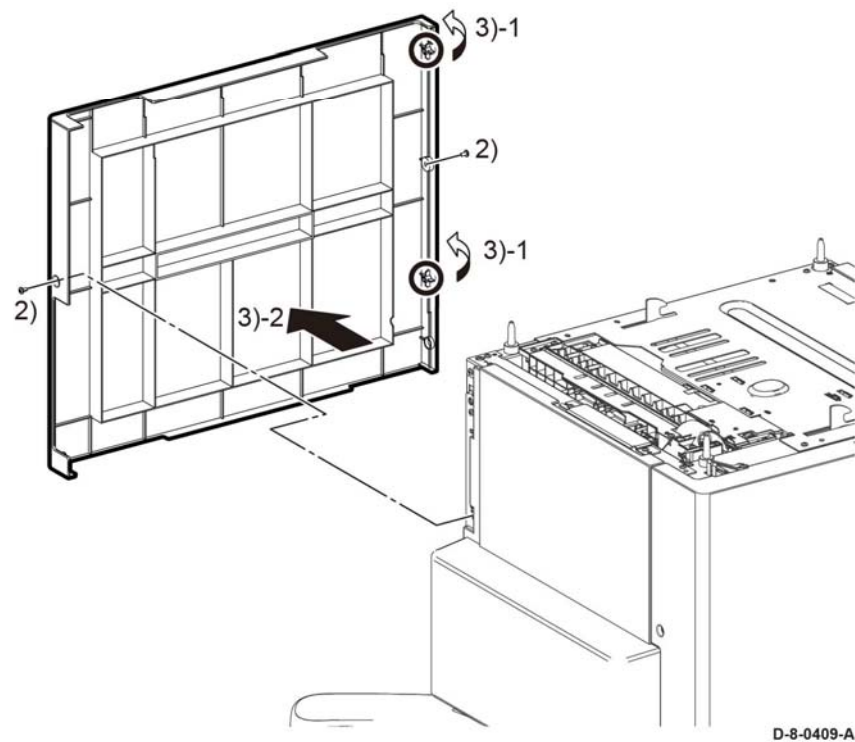
Figure 1 Right side cover

1. Open the HCF tray.
2. Remove two screws SM18, [Figure 1](#).
3. Perform the steps that follow, [Figure 1](#):
  - 3-1. Release two hooks.
  - 3-2. Remove the right side cover.

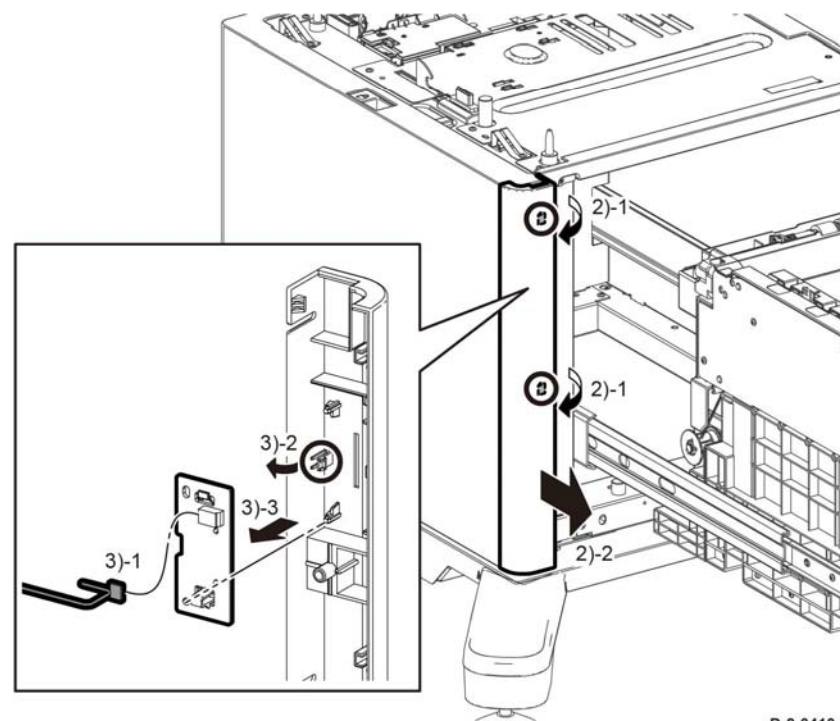
Figure 1 Left front cover, shade tray LED and PWB

In Step 2, do not damage the Shade Tray Cover LED and PWB as they are still attached to the left front corner.

2. Perform the steps that follow:
  - 2-1. Release two hooks, [Figure 1](#).
  - 2-2. Remove the cover front L.
3. Perform the steps that follow, [Figure 1](#):
  - 3-1. Disconnect connector [P/J814](#).
  - 3-2. Release the hook.
  - 3-3. Remove the shade tray LED and PWB.

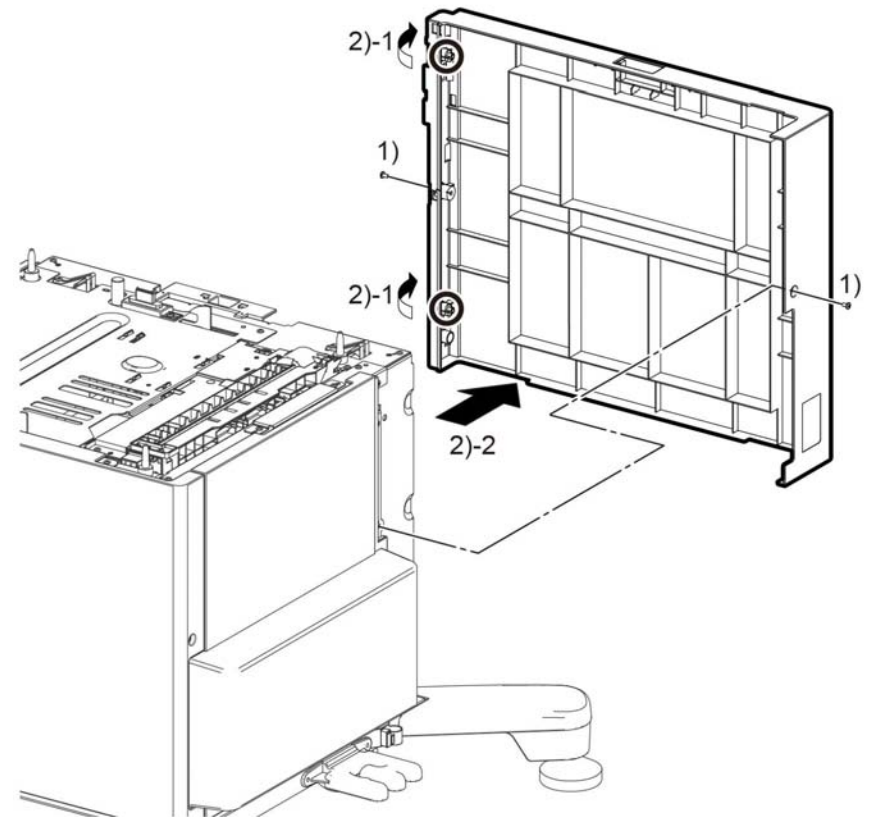
Figure 1 Left side cover

1. Remove two screw SM18. [Figure 1](#):
2. Perform the steps that follow:
  - 2-1. Release two hooks.
  - 2-2. Remove the left side cover.

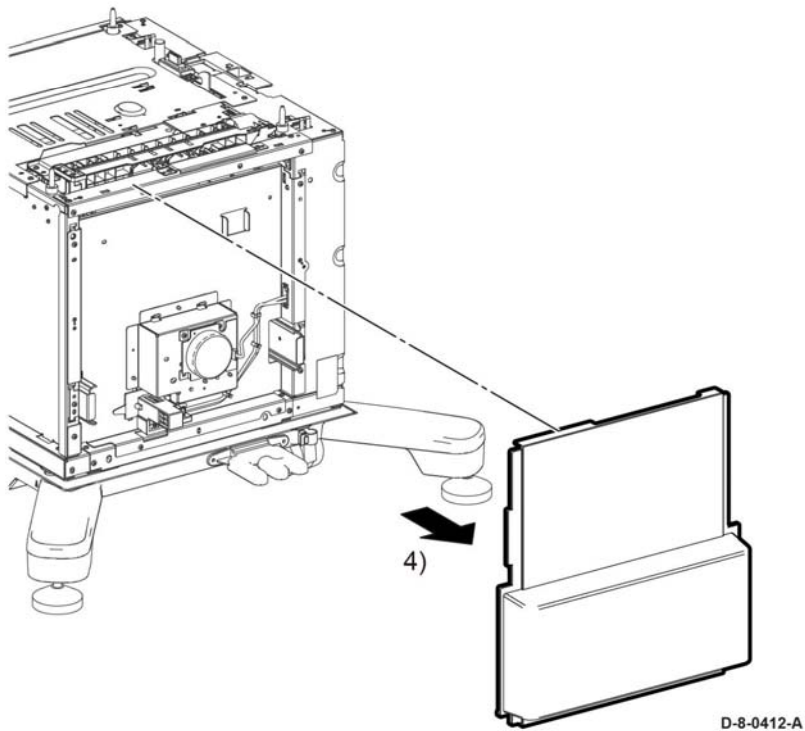
Figure 1 Rear cover

1. Remove the left front corner, shade tray LED, PWB LED cover, [REP 11.2](#).
2. Remove left side cover, [REP 11.3](#).
3. Remove the right side cover, [REP 11.1](#).
4. Remove the rear cover, [Figure 1](#).

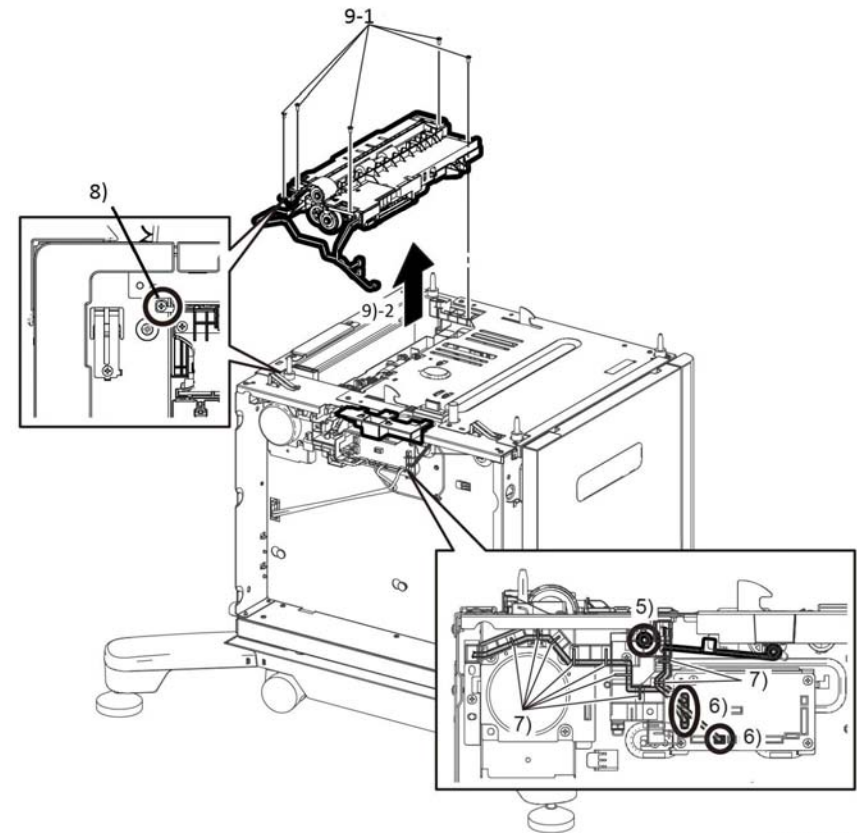
Figure 1 Feeder removal

If the screw and ground plate in the next step is not removed, the ground plate could be damaged when the feeder is removed.

8. Remove one screw and the ground plate on the feeder, Figure 1.
9. Perform the steps that follow, Figure 1:
  - 9-1. Remove five screws, ST20.
  - 9-2. Remove the feeder and harness assembly.

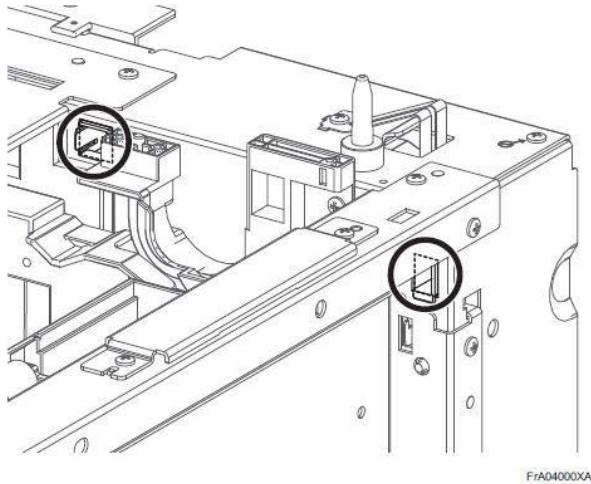
Figure 2 Holes in frame

1. The replacement is the reverse of the removal procedure.
2. Be sure to insert the harness assembly through the holes in the frame, [Figure 2](#).

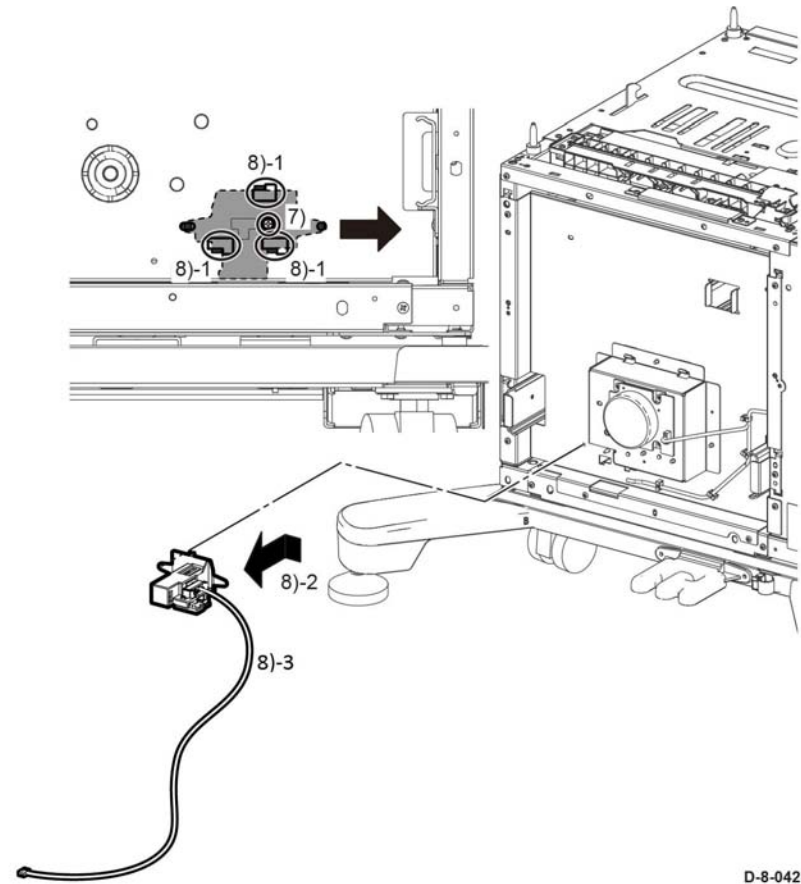
Figure 2 Rear interlock switch removal

7. Remove one screw, ST20, [Figure 2](#).
8. Perform the steps that follow, [Figure 2](#):
  - 8-1. Move the rear interlock switch in the direction shown to release three hooks.
  - 8-2. Remove the rear interlock switch.
  - 8-3. Disconnect the harness from the rear interlock switch.

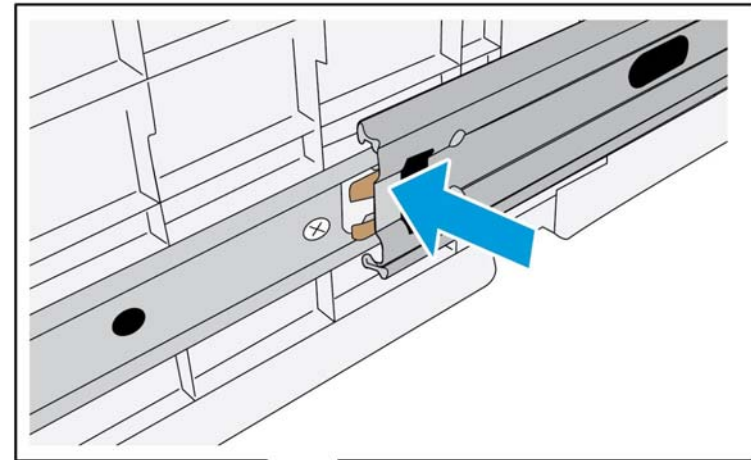
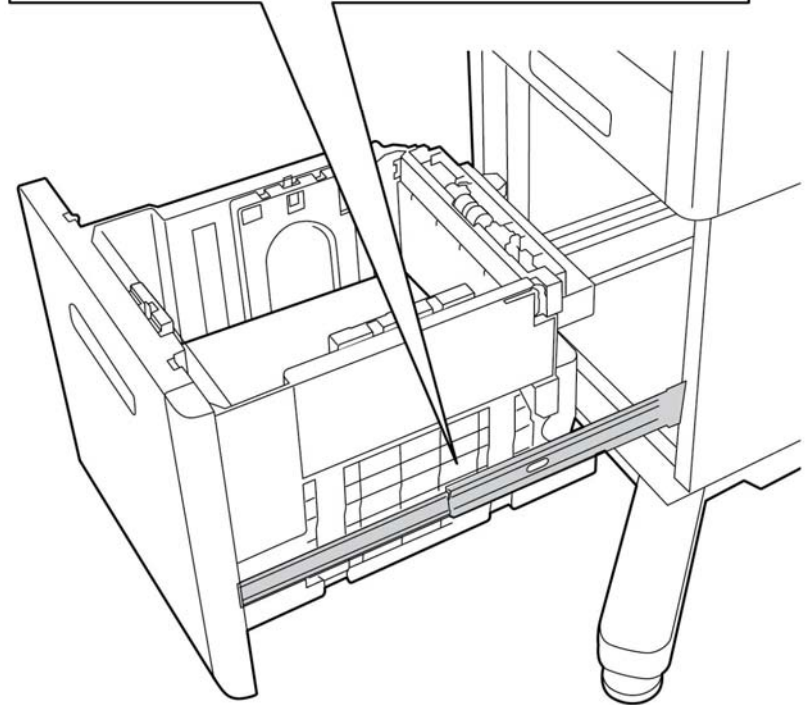
Figure 1 Releasing the feeder drawer

1. Pull the HCF feeder drawer out until it stops.
2. Push in the spring-loaded hatch one on each side, to remove the HCF feeder drawer, [Figure 1](#).

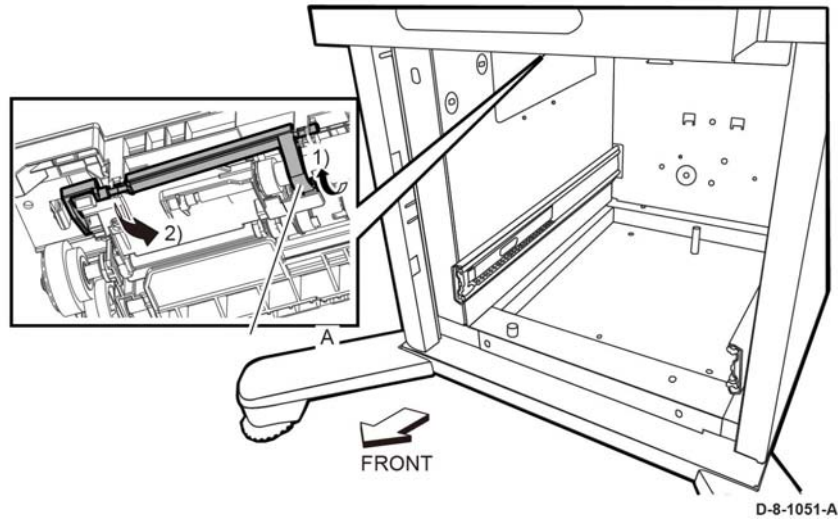
**Figure 2 Remove feed and separation lever**

3. Pull and lift the HCF feeder drawer off the slide-rails to remove the HCF feeder drawer.
4. Perform the items that follow, [Figure 2](#):
  - 4-1 Rotate the lever.
  - 4-2 Remove the feed and separation lever.

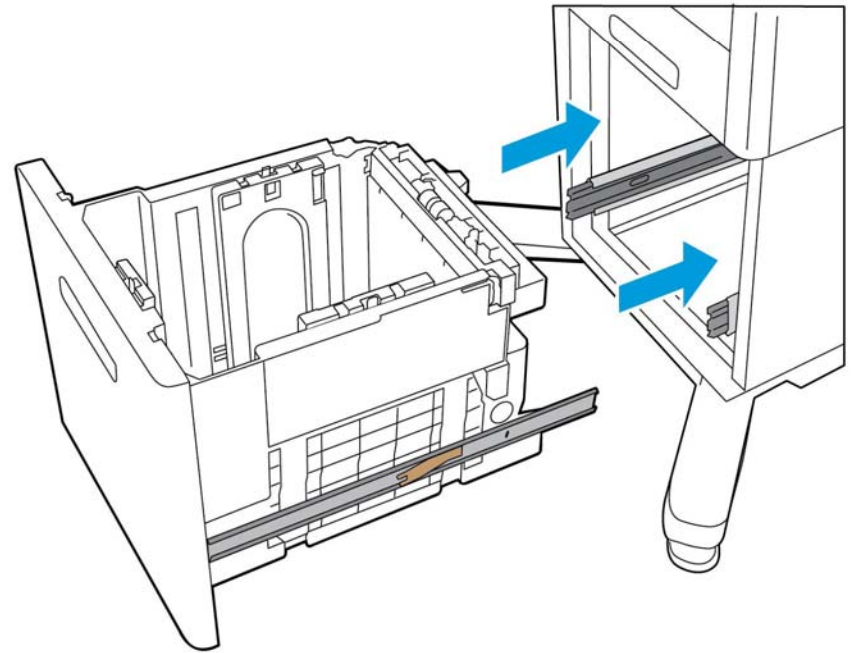
**Figure 3 Installing the HCF feeder drawer**

1. Push both slide rails all the way into the cabinet, [Figure 3](#).
2. Align the side rails, on the rear of the HCF feeder drawer, with the slide rails in the cabinet.
3. Push the HCF feeder drawer into place.

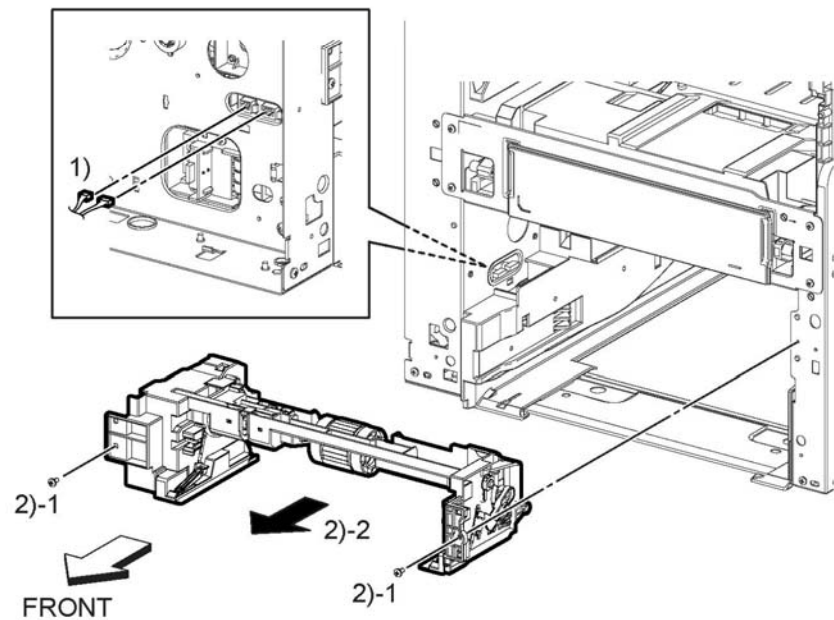
Figure 1 Frame assembly removal

1. Disconnect two connectors, [P/J482](#), [P/J483](#).
2. Remove the items that follow:
  - 2-1 Two screws, SM 18.
  - 2-2 Bypass tray frame assembly.

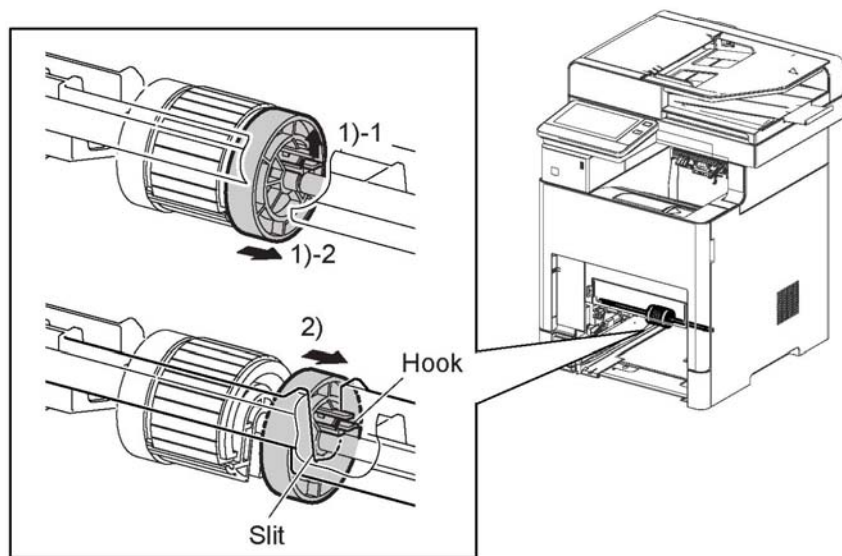
Figure 1 Release the bypass tray feed roller hook

1. Perform the items that follow, Figure 1:
  - 1-1 Release the hook.
  - 1-2 Slide the feed roll
2. Align the hook with the slit and slide it down the shaft, Figure 1.

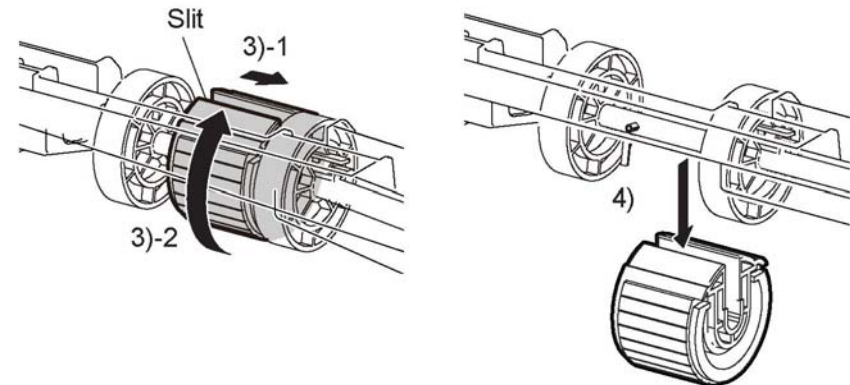
Figure 2 Remove the bypass tray feed roller

3. Perform the items that follow, Figure 2:
  - 3-1 Slide the bypass tray feed roll up the shaft.
  - 3-2 Rotate the bypass tray feed roll as shown.
4. Remove the bypass tray feed roll from the shaft, Figure 2.
5. Remove the bypass tray feed roller, Figure 2.

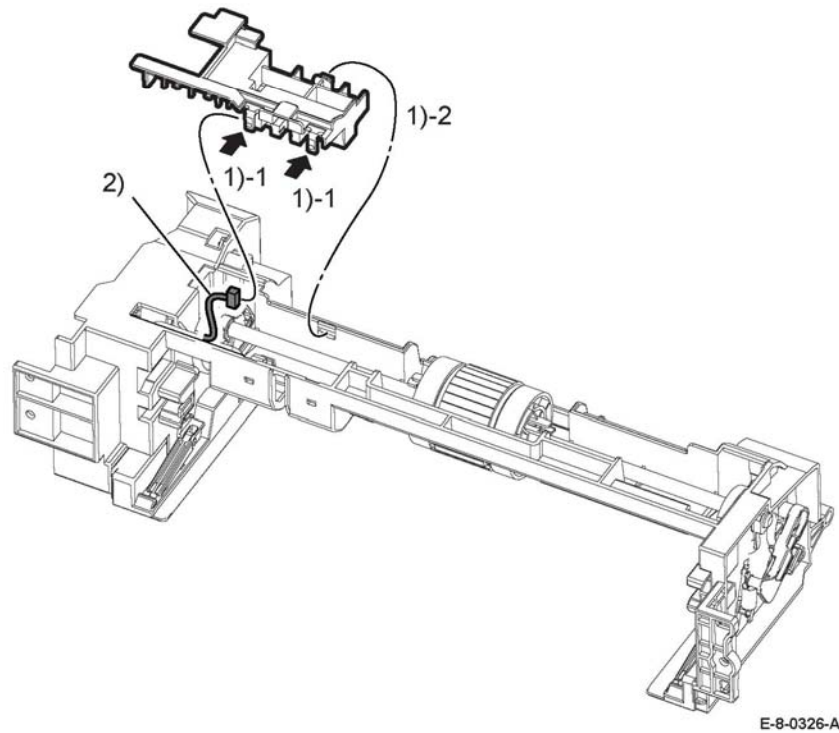
Figure 1 Remove the bypass tray no paper bracket

1. Perform the items that follow, Figure 1:
  - 1-1 Release two hooks and the boss.
  - 1-2 Remove the bypass no paper sensor bracket from the bypass frame assembly.
2. Disconnect connector P/J484 and release the harness.

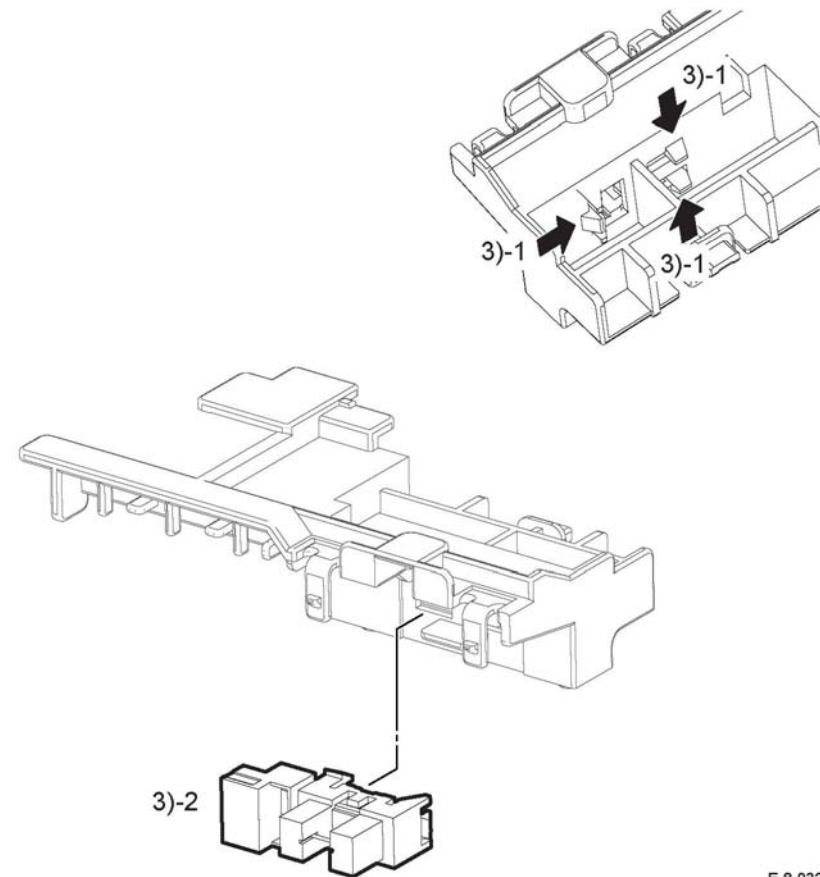
Figure 2 Remove the bypass tray no paper sensor

3. Perform the items that follow, Figure 2:
  - 3-1 Release the three hooks
  - 3-2 Remove the bypass no paper sensor.

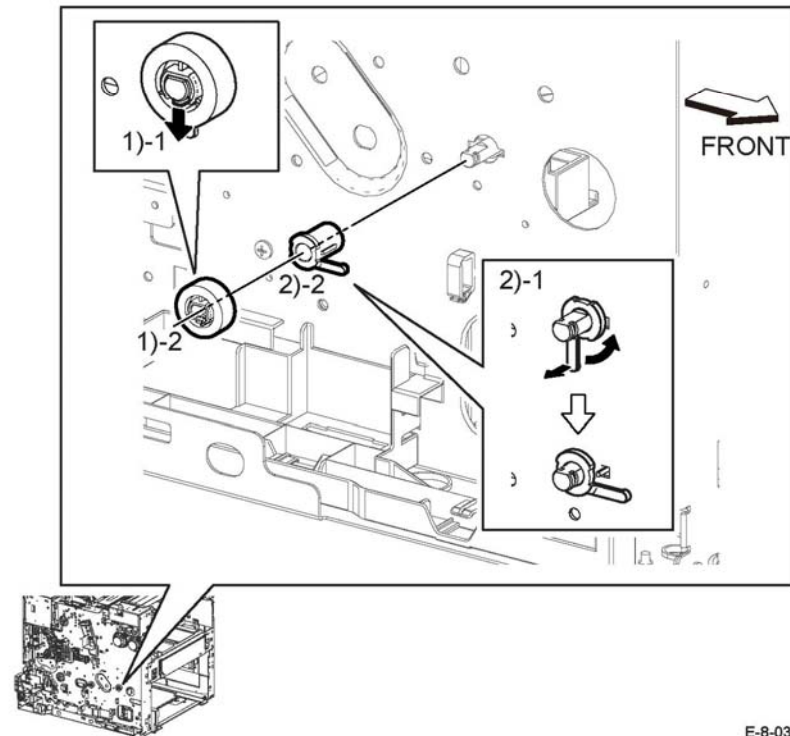
Figure 1 Remove the bypass tray TA1 roller assembly

In the following step, avoid breaking the bearing tab by lifting the hook gently during bearing removal.

2. Perform the items that follow, [Figure 1](#):
  - 2-1 Release the hook.
  - 2-2 Remove the left turn around bearing

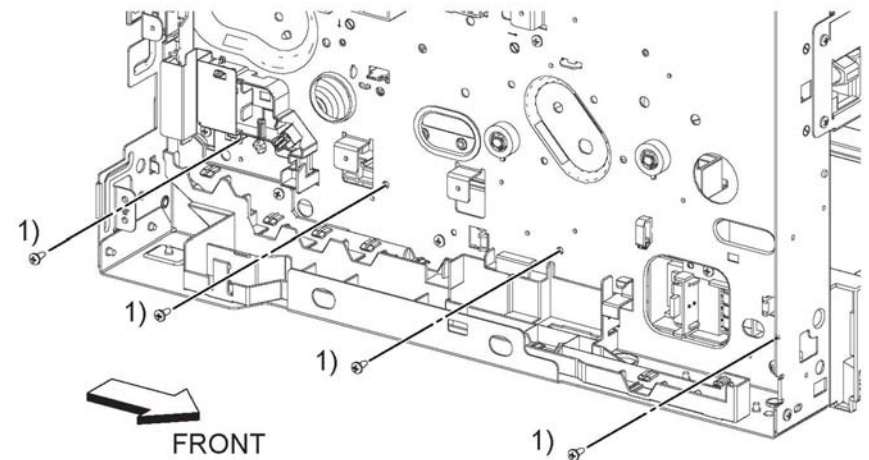
Figure 1 Remove the screws

1. Remove four screws (ST 20) holding the guide tray, [Figure 1](#).

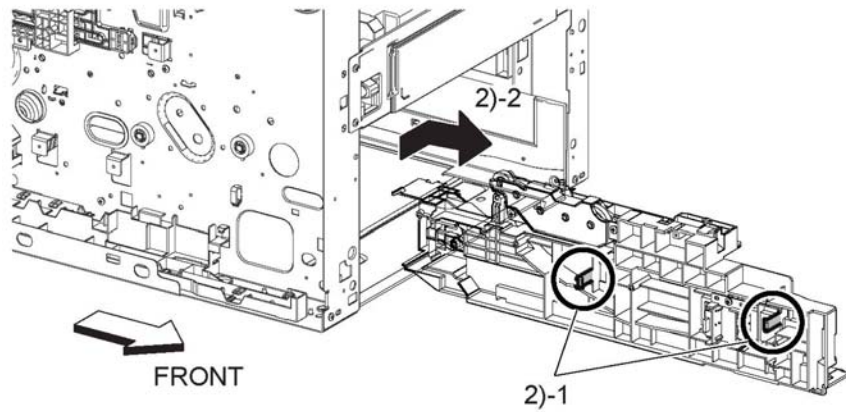
**Figure 2 Remove the guide tray**

2. Perform the items that follow, [Figure 2](#):
  - 1-1 Release two hooks.
  - 1-2 Remove the guide tray.

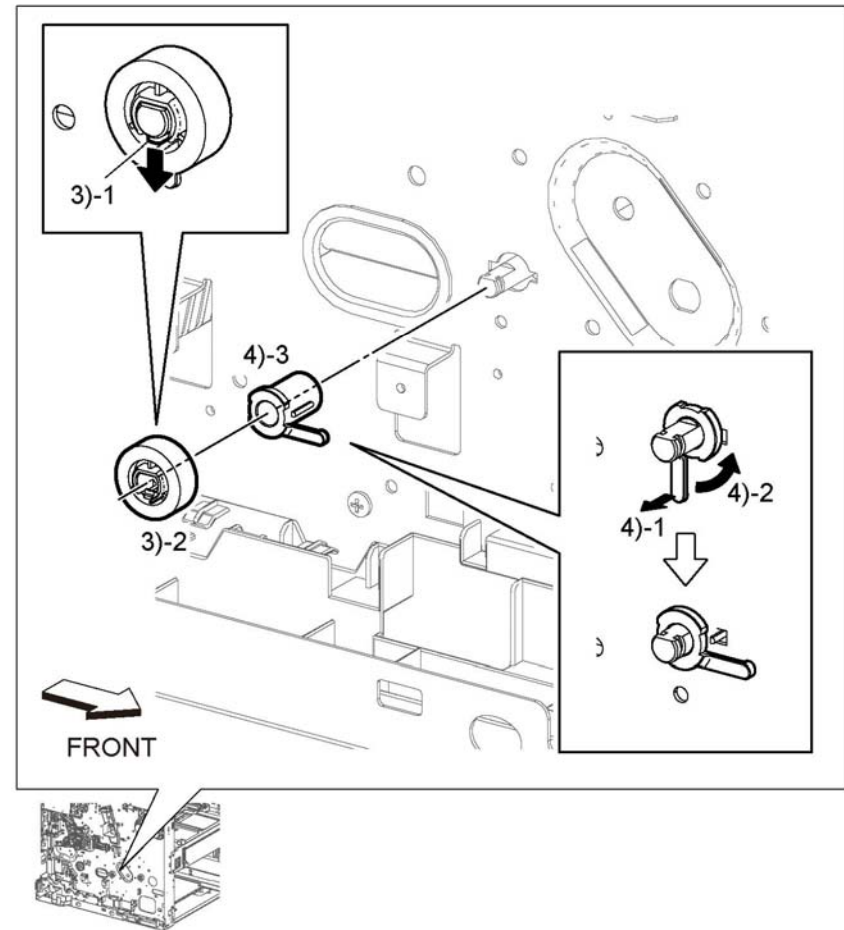
**Figure 3 Remove the bypass tray TA 2 roller assembly**

4. Perform the items that follow, **Figure 3**:

- 4-1 Release the hook
- 4-2 Remove the left turn around bearing.

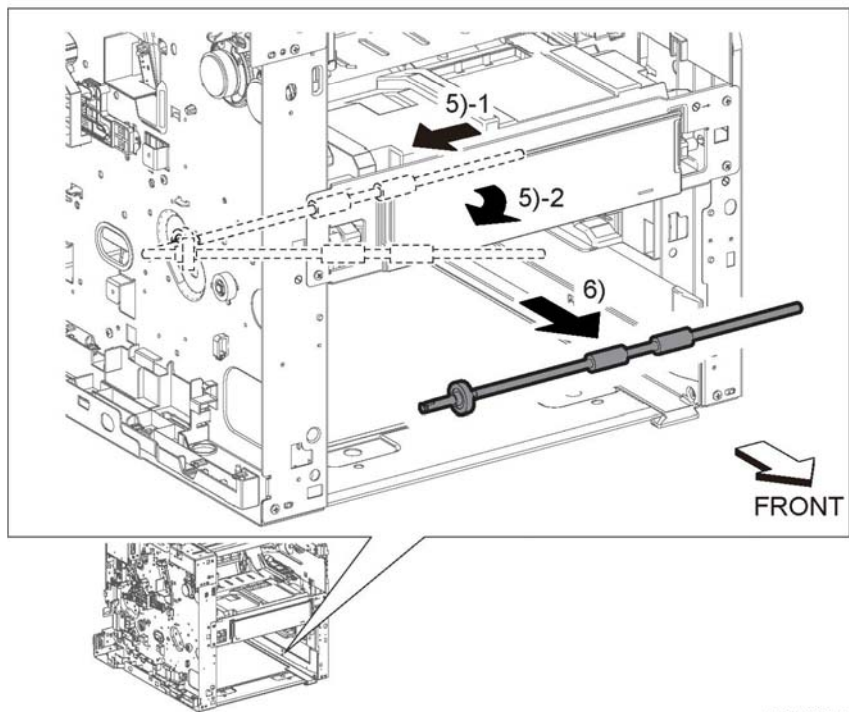
Figure 4 Remove the turn around roller 2

- 5-1 Slide the turn around roller 2 to the left.
- 5-2 Rotate the turn around roller 2 downward.

6. Remove the turn around roller assembly 2 in the direction of the arrow.

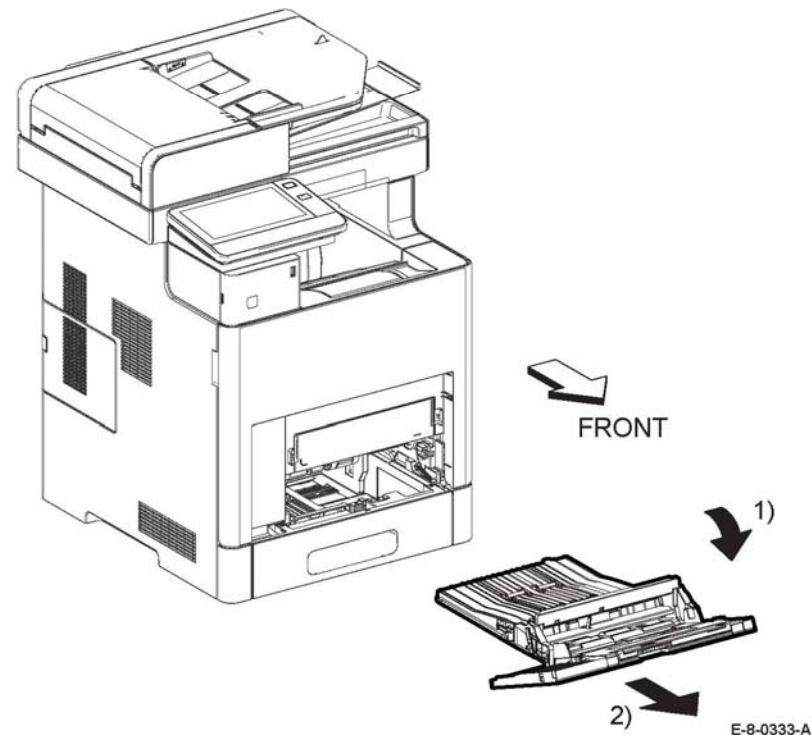
Figure 1 Remove the main bypass tray

1. Open the MSI main tray assembly, [Figure 1](#).
2. Remove the MSI main tray assembly.

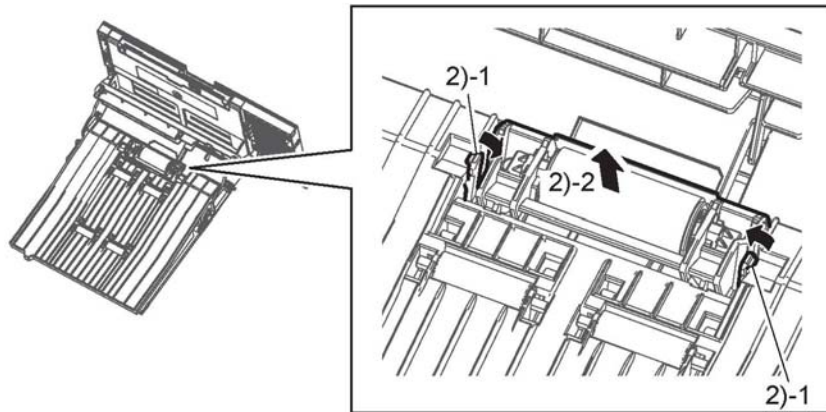
Figure 1 Remove the bypass tray separator holder assembly

1. Remove the main bypass tray assembly, [REP 13.6](#).
2. Perform the items that follow, [Figure 1](#):
  - 2-1 Release the two hooks
  - 2-2 Remove the bypass separator holder assembly from the main bypass tray assembly.

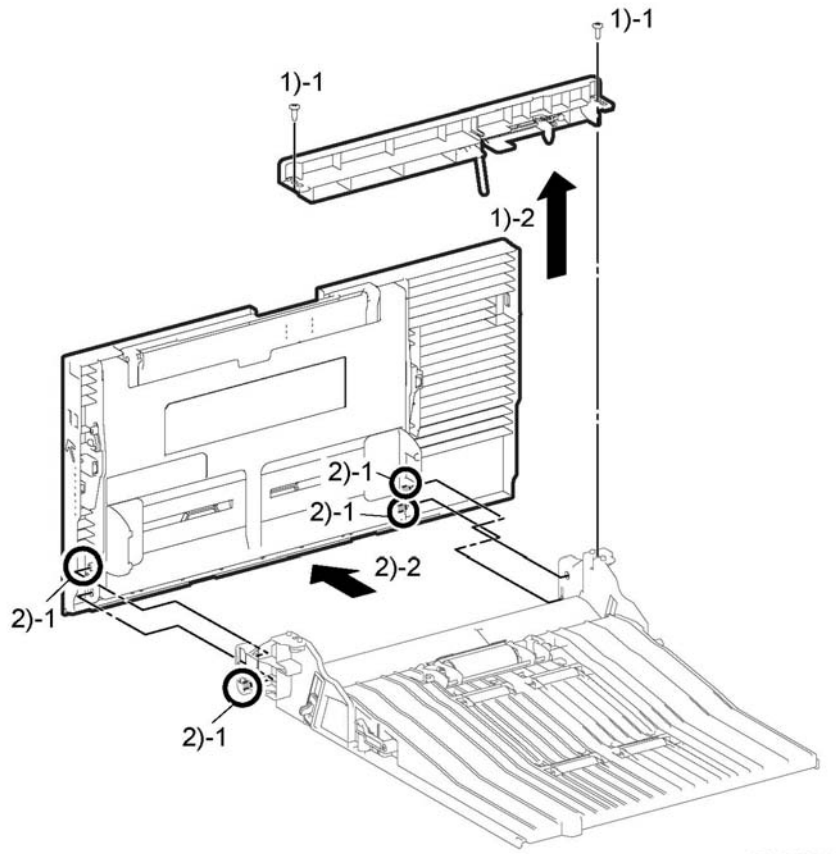
Figure 1 Remove the bypass cover assembly

1. Perform the items that follow, [Figure 1](#):
  - 1-1 Remove two screws (ST20).
  - 1-2 Remove the front bypass bar.
2. Perform the items that follow, [Figure 1](#):
  - 2-1 Flex the bypass chute to release the four bosses.
  - 2-2 Remove the bypass cover assembly.

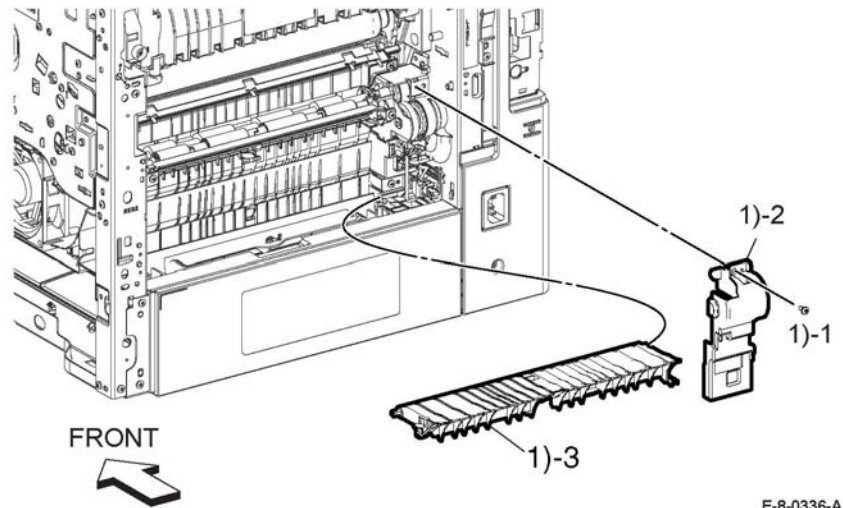
Figure 1 Lower duplex chute removal

1. Remove the lower duplex chute, Figure 1:
  - 1 One screw.
  - 2 Duplex rear cover.
  - 3 Rotate the lower duplex chute 90° remove the lower duplex chute.

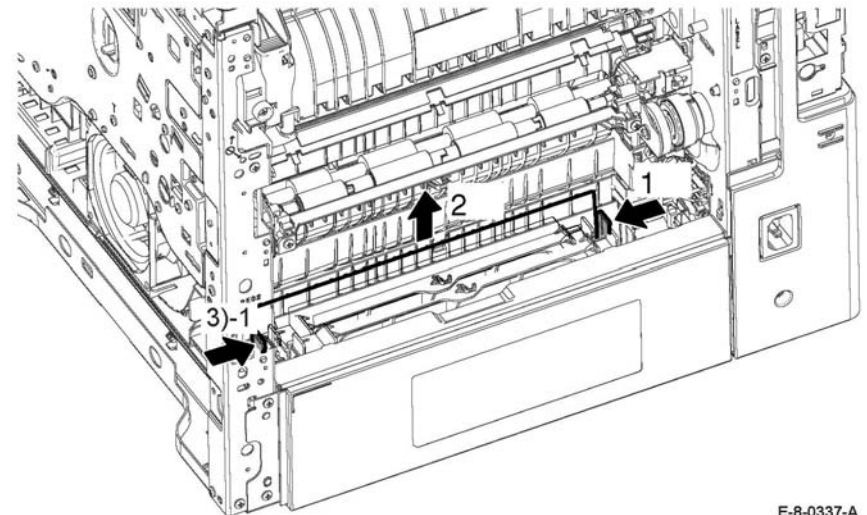
Figure 2 Optional 550 chute removal

2. Remove the optional 550 chute, Figure 2:

- 1 Release two hooks.
- 2 Remove the optional 550 chute.

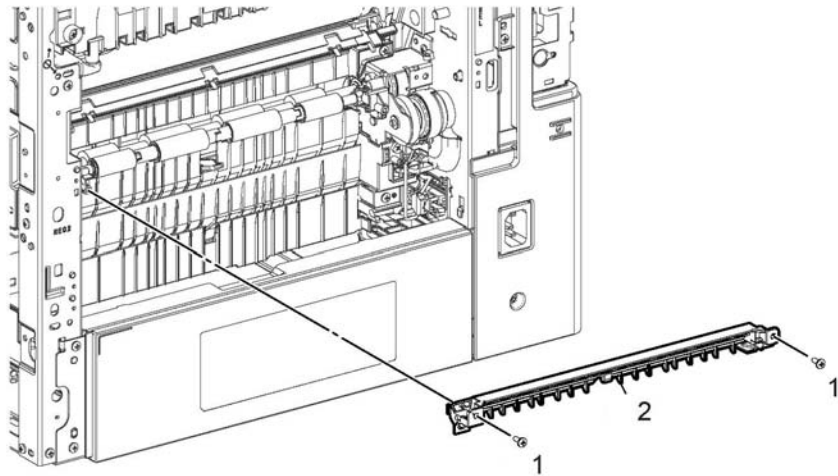
E-8-0338-A

1 Two screws.

2 Upper duplex chute.

**Figure 3 Upper duplex chute removal**

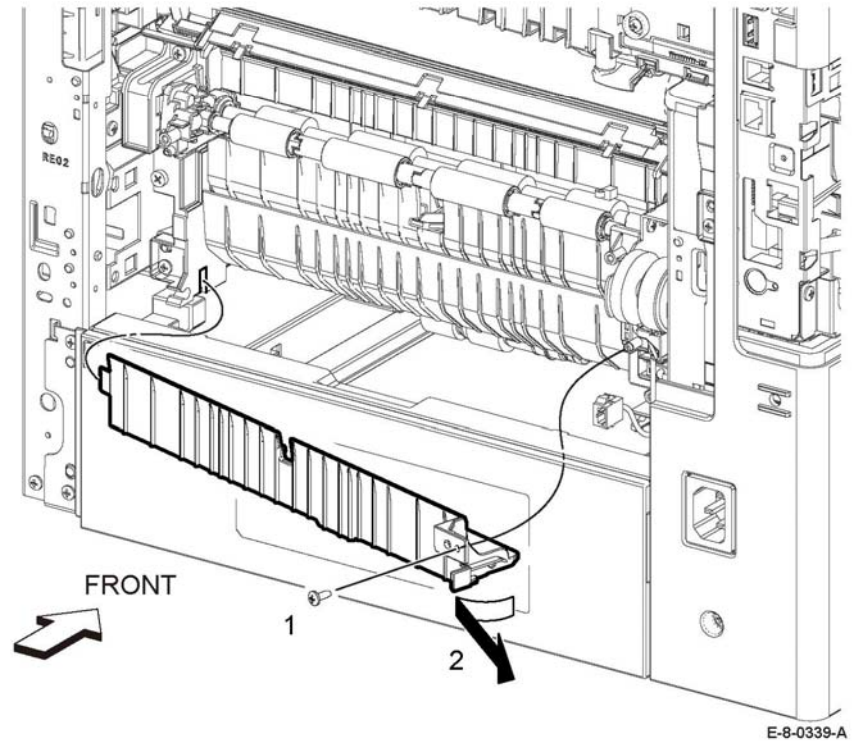
E-8-0339-A

1 Remove one screw.

2 Pull the feeder chute out as shown.

**Figure 4 Feeder chute removal**

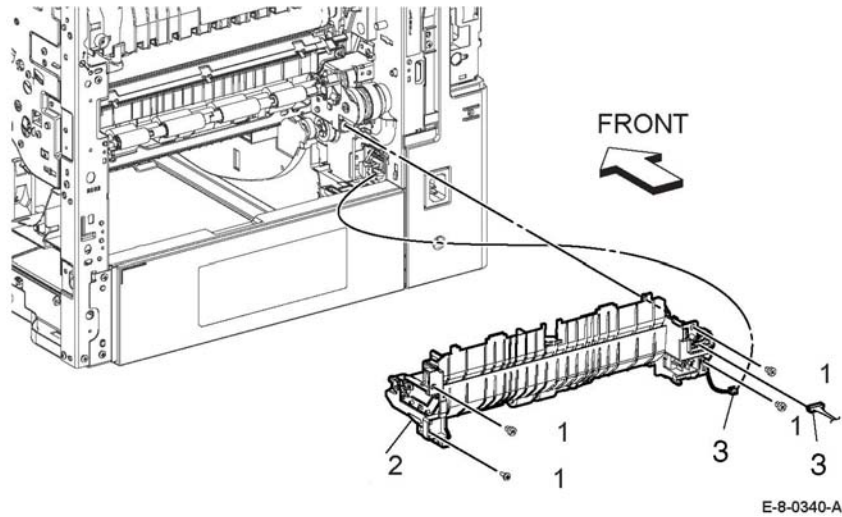
E-8-0340-A

5. Remove the feeder registration chute assembly, **Figure 5**:
  - 1 Four screws.
  - 2 Registration feeder chute assembly.
  - 3 Disconnect two connectors.

**Figure 5 Remove the feeder registration chute assembly**

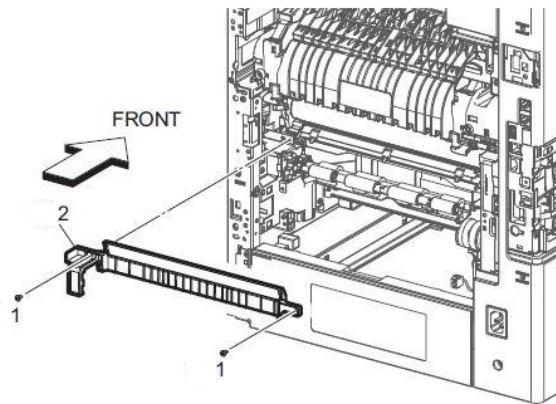
VI04139XA

1. Remove the upper chute assembly, [Figure 1](#).
  - a. Remove two screws (1).
  - b. Remove the upper chute assembly (2).

Figure 1 Remove the duplex registration roller assembly

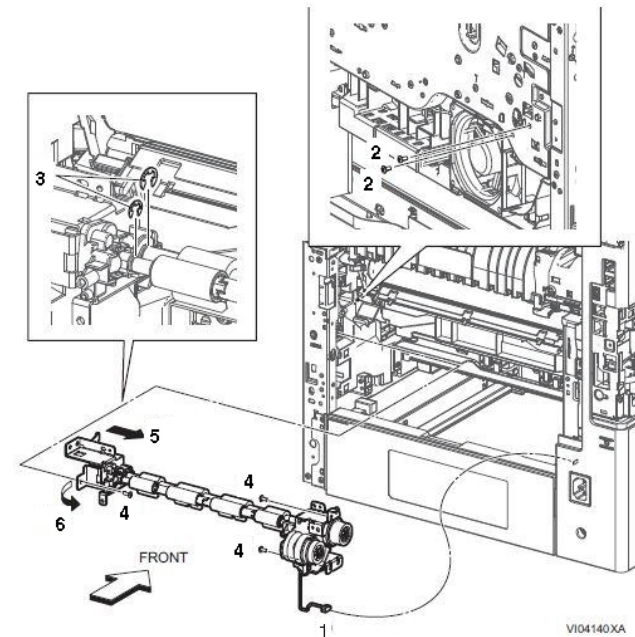
VI04140XA

**NOTE:** When removing the Duplex Roller Registration Assembly, bearings and gears will move out of their seated positions. For easier replacement later, carefully observe the placement and orientation of bearings and gears at both ends of the roller assembly before removing it.

- c. Remove the two E-rings (3) from the duplex registration roller assembly.
- d. Remove three screws (4).
- e. Slide the duplex roll assembly in the direction of the arrow (5).
- f. Remove the duplex registration roll assembly in direction of the arrow (6).

Figure 2 Remove the duplex registration roll assembly

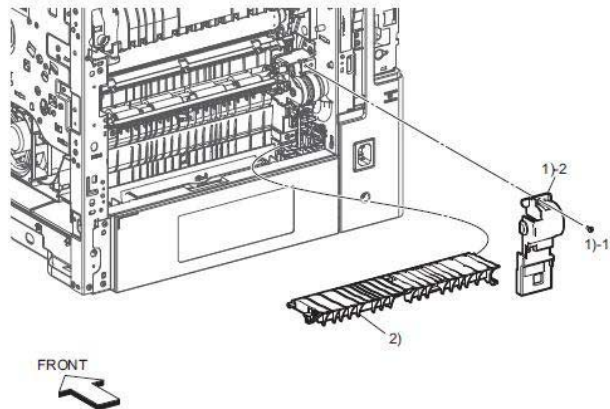
VI04130XA

1-1 One screw.

1-2 Duplex rear cover.

Figure 1 Remove lower duplex chute

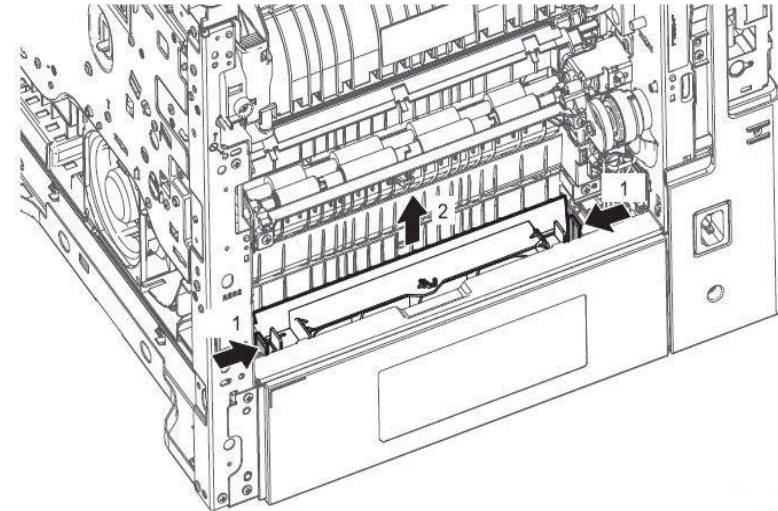
VI04131XA

2. Remove the optional 550 chute, Figure 2:
  - a. Rotate the lower duplex chute 90° remove the lower duplex chute.
  - b. Release two hooks (1).
  - c. Remove the optional 550 chute (2) in the direction of the arrow.

Figure 2 Remove the optional 550 chute

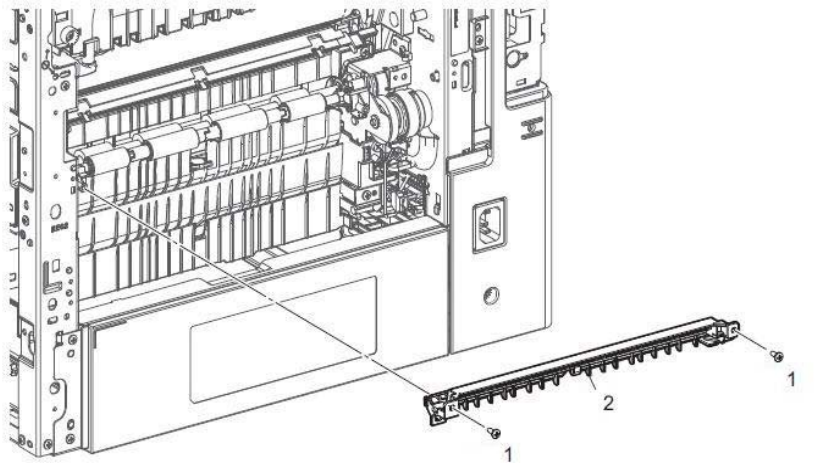
3. Remove the upper duplex chute, **Figure 3**:
  - a. Remove two screws (1).
  - b. Remove the upper duplex chute (2).

**Figure 3 Remove upper duplex chute**

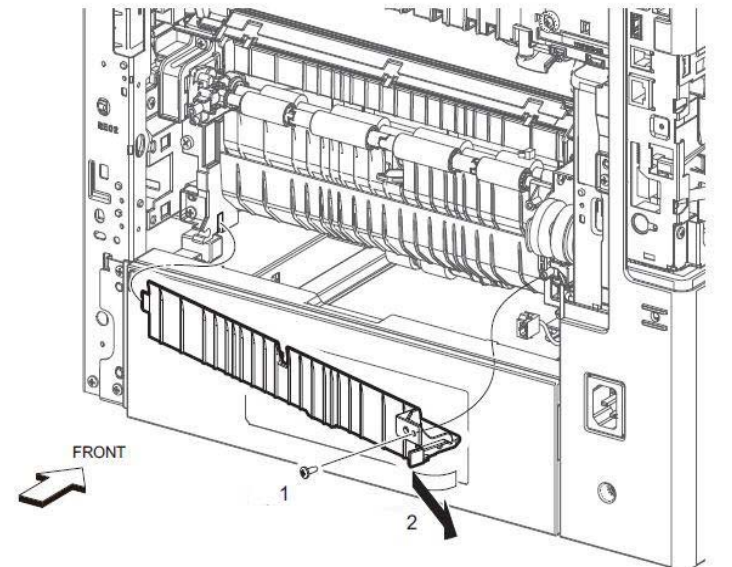
4. Remove the feeder chute, **Figure 4**:
  - Remove the screw (1).
  - Remove the feeder chute (2) in the direction of the arrow.

**Figure 4 Remove feeder chute**

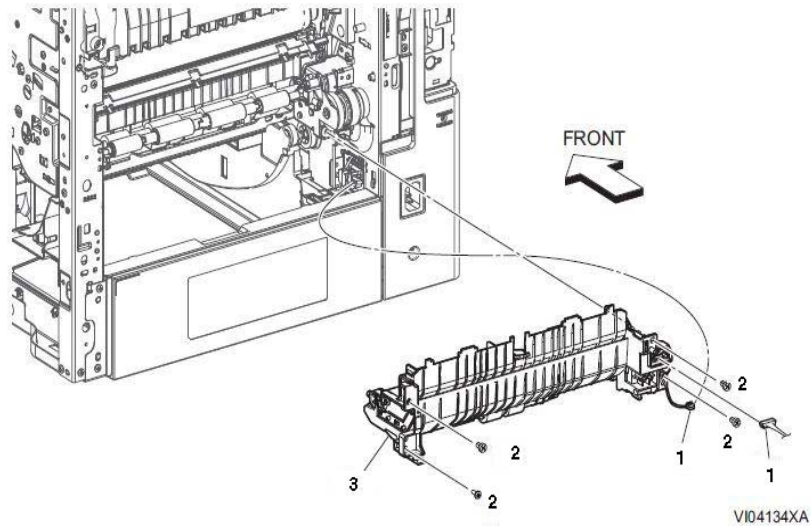
5. Remove the registration feeder chute assembly, [Figure 5](#):
  - a. Disconnect two connectors (1), [P/J544](#), [P/J545](#).
  - b. Remove four screws (2).
  - c. Remove the registration feeder chute assembly (3).

**Figure 5 Remove registration chute assembly**

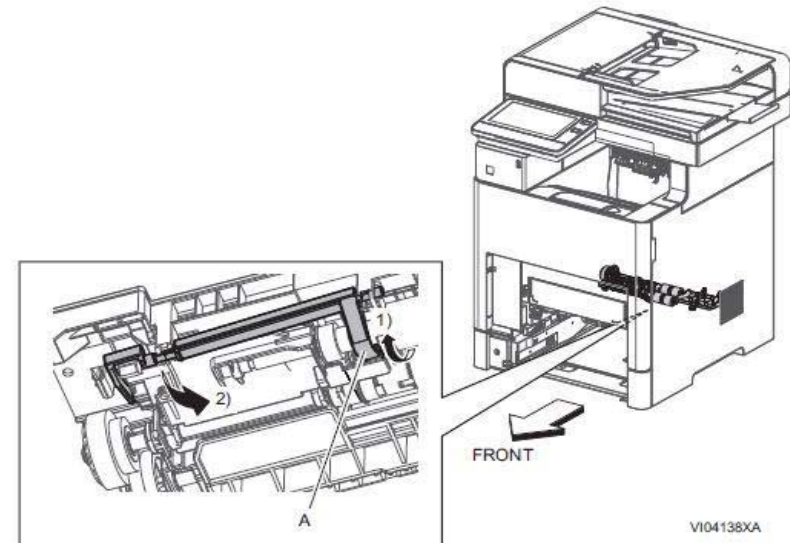
1. Remove the no paper actuator, [Figure 1](#):
  - a. Release the tab (A).
  - b. Remove the no paper actuator in the direction of the arrows.

**Figure 1 Remove the no paper actuator**

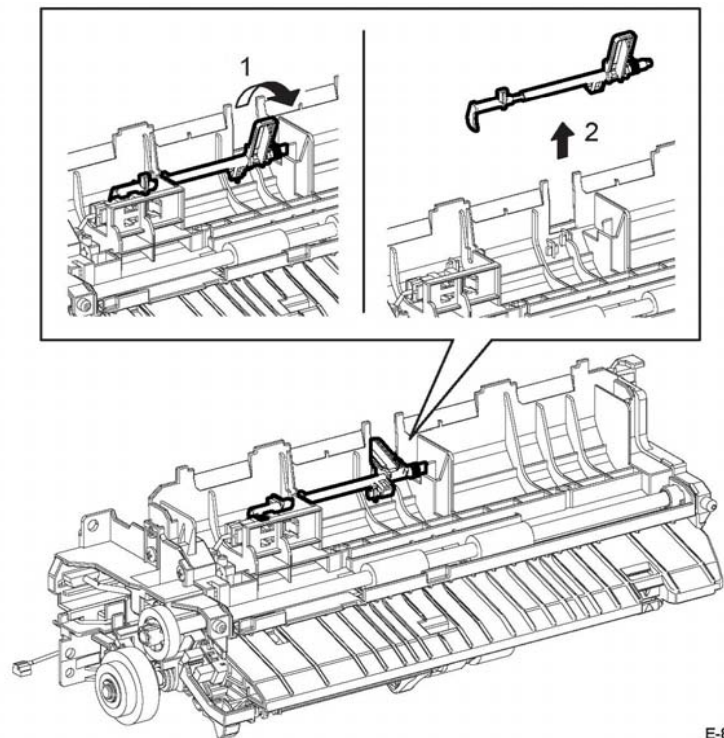
*In the following step, avoid losing the spring from the end of the Registration Actuator when removing the actuator.*

1. Remove the registration actuator assembly, [Figure 1](#):
  - a. Rotate the registration actuator assembly in the direction of the arrow (1).
  - b. Remove the registration actuator assembly in the direction of the arrow (2).

Figure 1 Remove the registration actuator assembly
