# VersaLink® B600/B610 Printer and B605/B615 Multifunction Printer Service Manual

Xerox® VersaLink® B600 Family MFP Service Manual

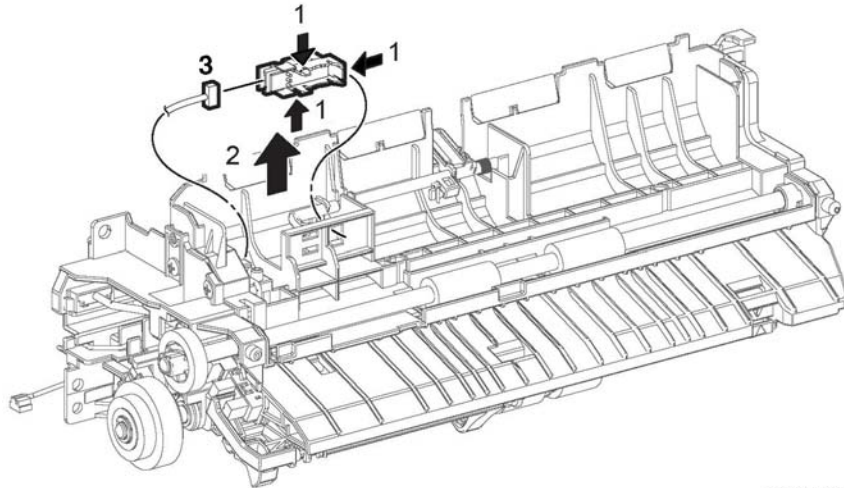
E-8-0342-A

1. Remove the registration sensor, [Figure 1](#):
  - a. Release three hooks (1).
  - b. Lift up the registration sensor (2).
  - c. Disconnect connector [P/J546](#) (3), then remove the registration sensor (2).

Figure 1 Remove the registration sensor

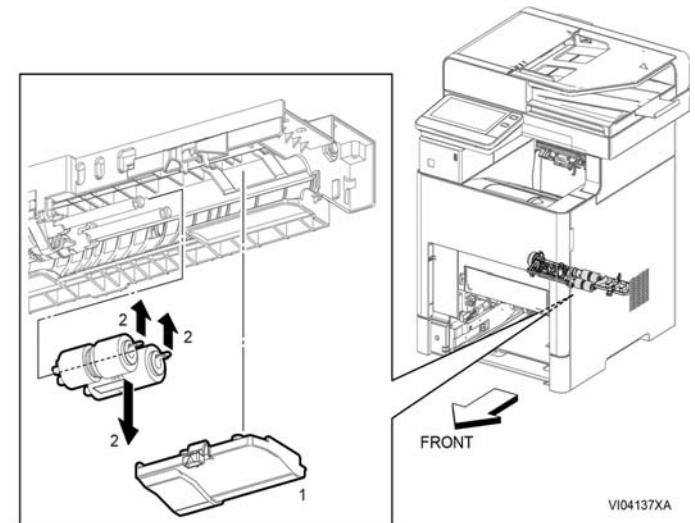
VI04137XA

1. Perform the items that follow, [Figure 1](#):
  - a. Remove the upper feed chute (1).
  - b. Remove the feed roll assembly in the direction of the arrows (2).

Figure 1 Remove upper feed chute

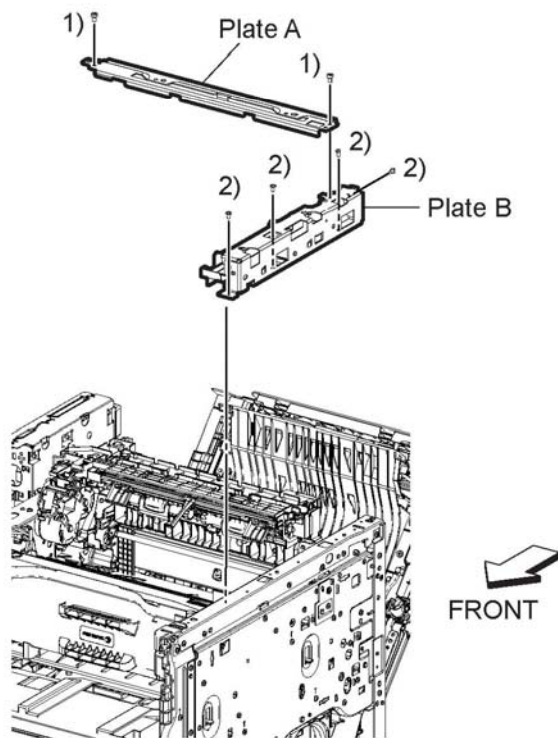
1. MFP-Tall and SFP models only, remove two screws (SM18) to remove plate A., [Figure 1](#).
2. MAP-Tall and SFP models only, remove four screws (SM18) to remove plate B, [Figure 1](#).

Figure 1 Remove plate A and B

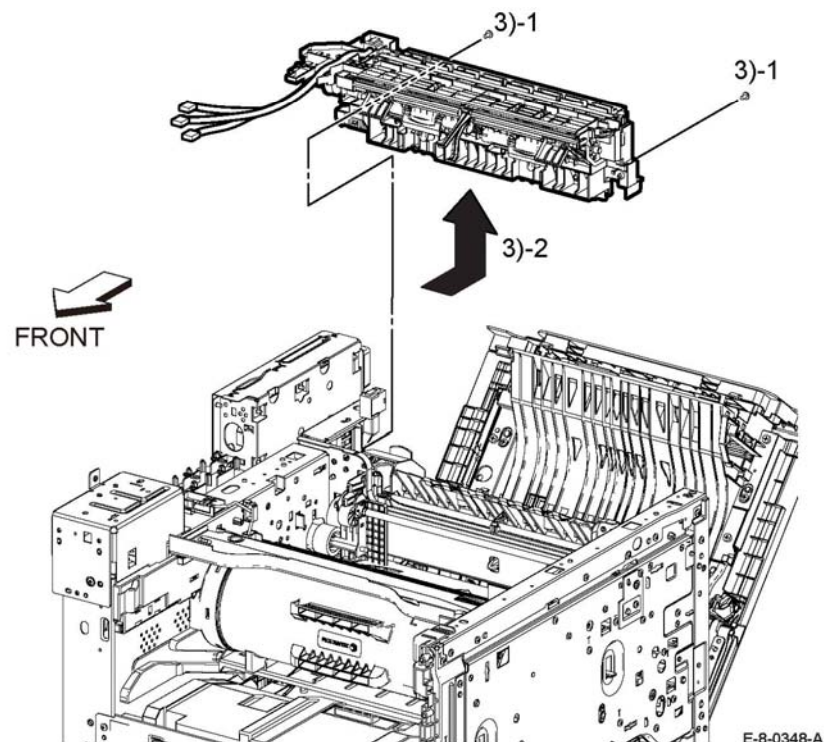
3. Remove the items that follow, [Figure 2](#):
  - 3-1 Two screws (SM18).
  - 3-2 Exit chute assembly.

Figure 2 Remove exit chute assembly

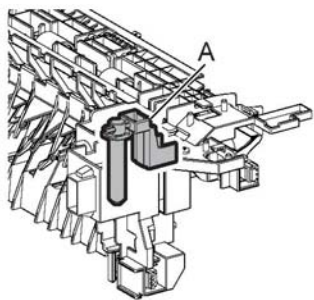
E-8-0525-A

When removing the exit chute assembly, do not turn the exit chute assembly over or part A may fall off, [Figure 3](#).

Figure 3 Chute exit assembly

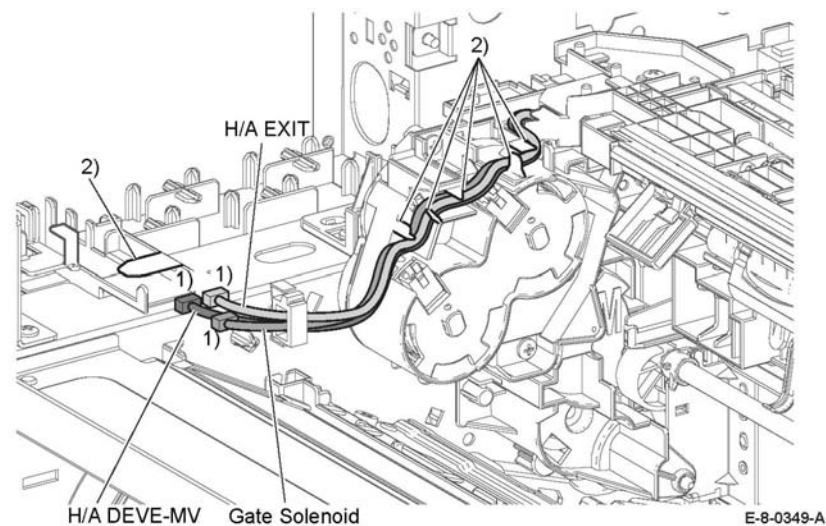
1. Disconnect connectors [P/J460](#), [P/J466](#), [P/J468](#), [Figure 1](#).
2. Release the harness from the harness guide.

Figure 1 Removing the main exit harness

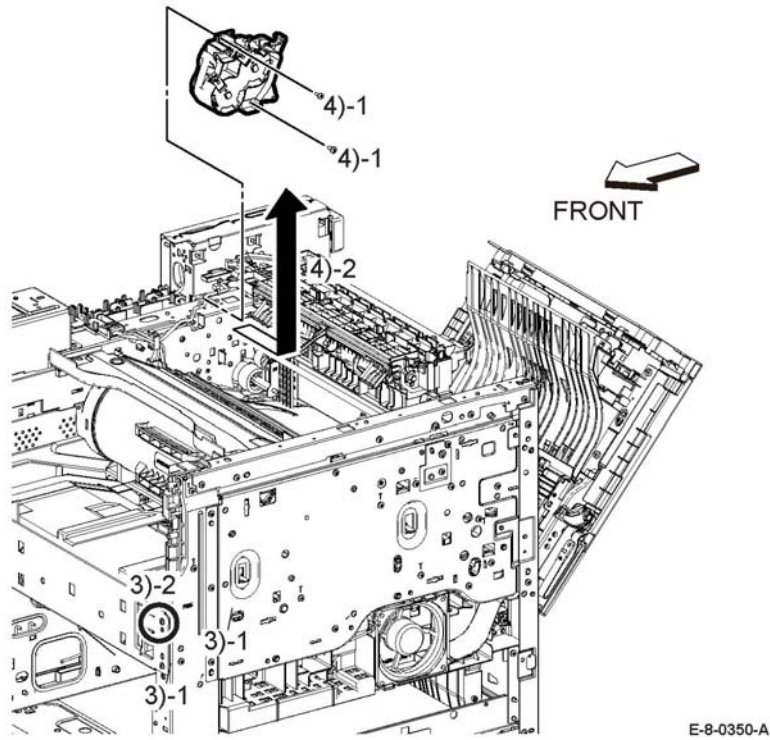
3. Perform the items that follow, [Figure 2](#):
  - 3-1 Disconnect connectors [P/J461](#), [P/J462](#).
  - 3-2 Release the harness from the harness guide.
4. Remove the items that follow, [Figure 2](#):
  - 4-1 Two screws (ST20).

4-2 Main exit drive assembly.

Figure 2 Remove the main exit drive assembly

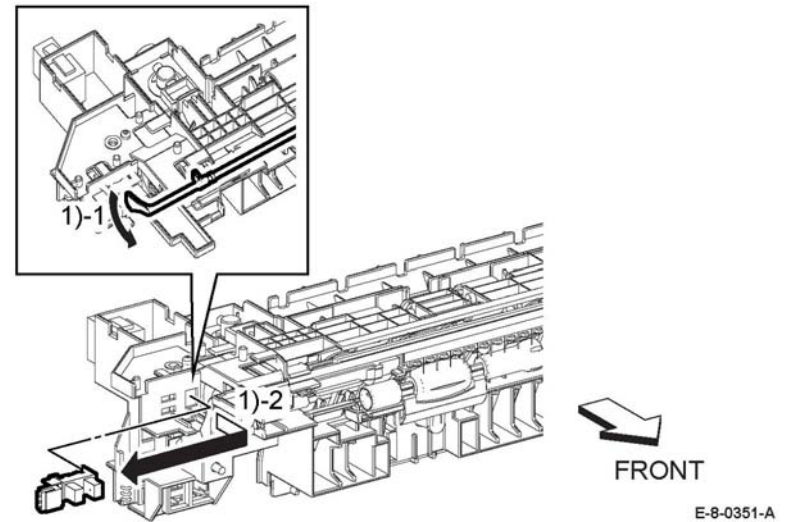
1. Perform the items that follow, [Figure 1](#):
  - 1-1 Rotate the full stack actuator.
  - 1-2 Remove the full stack sensor.

Figure 1 Remove the full stack sensor

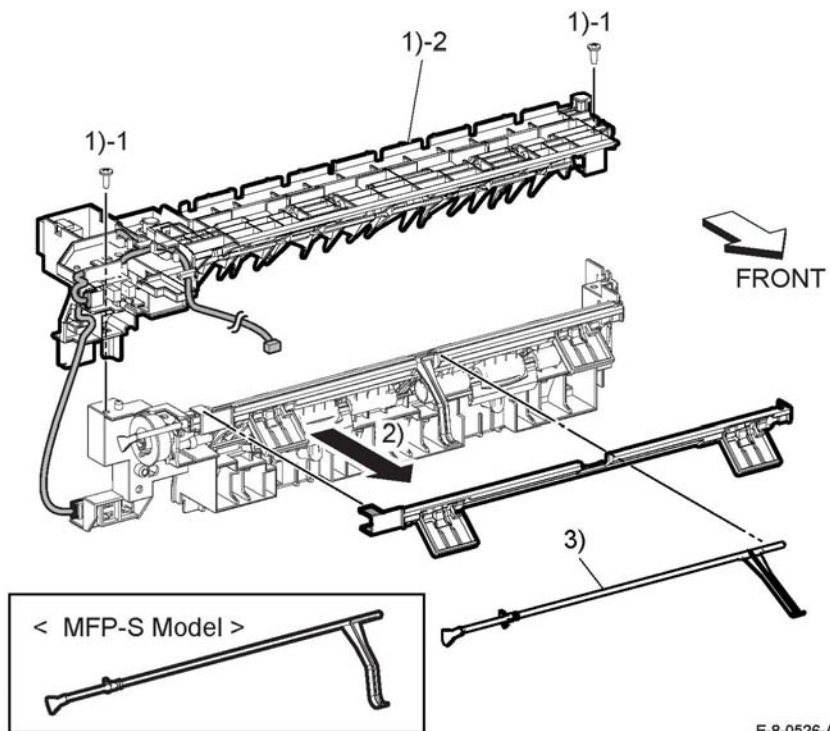
1. Perform the items that follow, [Figure 1](#):
  - 1-1 Remove two screws (ST20).
  - 1-2 Release the upper side of the exit chute assembly.
2. Release the hooks and remove the lower exit top cover with the exit flapper chute, [Figure 1](#).
3. Remove the stack full actuator.

Figure 1 Remove the stack full actuator

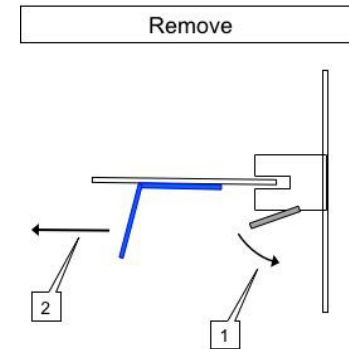
In the following step, engage the lever enough to release the FFC only. Over-engagement of the release lever will break the lever destroying the lock mechanism forcing replacement of the PWB.

**NOTE:** When engaging the release lever on the FFC connector, slightly open the release lever no more than 15 degrees. Hold the lever while gently removing the FFC from the connector as shown in [Figure 1](#).

Figure 1 Proper Removal of the FFC Cable

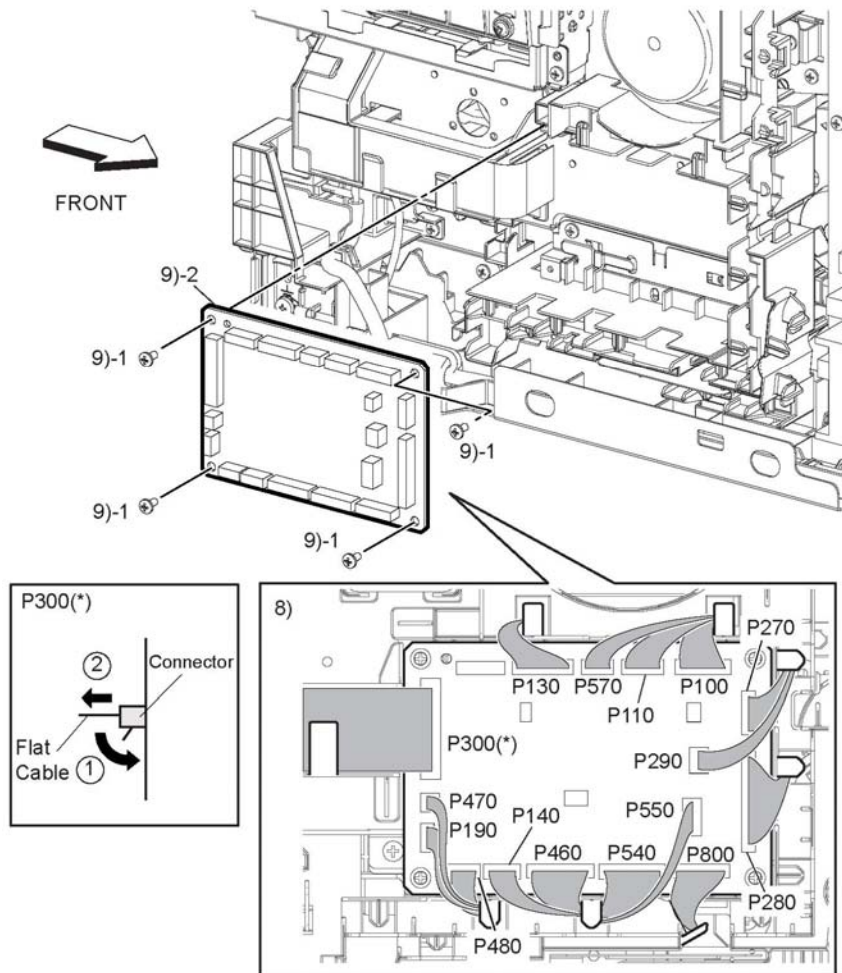
E-8-0354-A

8. Disconnect connectors [P/J100](#), [P/J110](#), [P/J130](#), [P/J140](#), [P/J190](#), [P/J200](#), [P/J270](#), [P/J280](#), [P/J290](#), [P/J460](#), [P/J480](#), [P/J540](#), [P/J550](#), [P/J570](#), [P/J800](#) and the FFC [P/J300](#), [Figure 2](#).
9. Remove the items that follow, [Figure 2](#):
  - 9-1 Four screws (SM18).
  - 9-2 MCU PWB.

Figure 2 Remove the MCU PWB

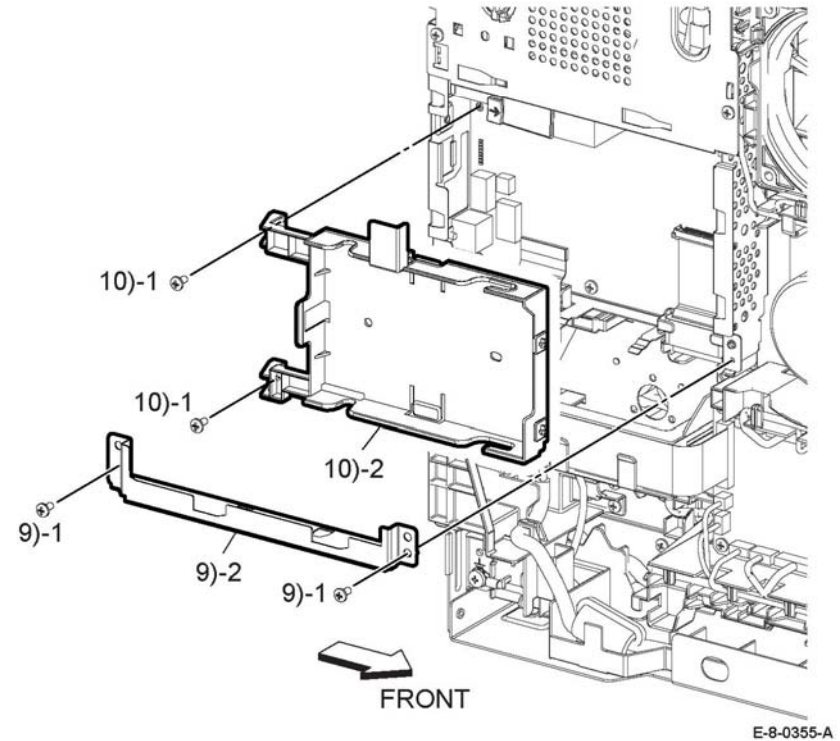
1. Remove the 550 IOT feed tray assembly [REP 9.1](#).
2. Remove the main bypass tray, [REP 13.6](#)
3. Remove the ESS window kit assembly [REP 19.17](#).
4. Remove the HDD assembly [PL 18.1 Item 27](#).
5. Remove the WIFI cap [REP 19.16](#).
6. Remove the front cover assembly [REP 19.1](#).
7. Remove the left front cover, LED PWB and shade tray cover, [REP 19.10](#).
8. Remove the left side cover, [REP 19.7](#).
9. Perform the items that follow, [Figure 1](#):
  - 9-1 Remove two screws (SM18).
  - 9-2 Remove the lower ESS plate.
10. Perform the items that follow, [Figure 1](#):
  - 10-1 Remove two screws (SM18).
  - 10-2 Remove the HDD bracket.

Figure 1 Remove the HDD bracket

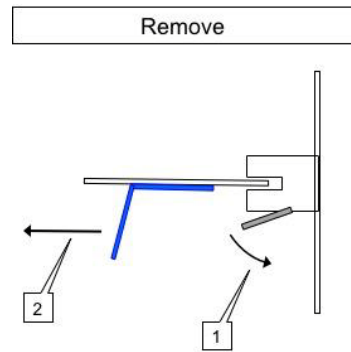
NOTE: When engaging the release lever on the FFC connector, slightly open the release lever no more than 15 degrees. Hold the lever while gently removing the FFC from the connector as shown in Figure 2.

Figure 2 Removal

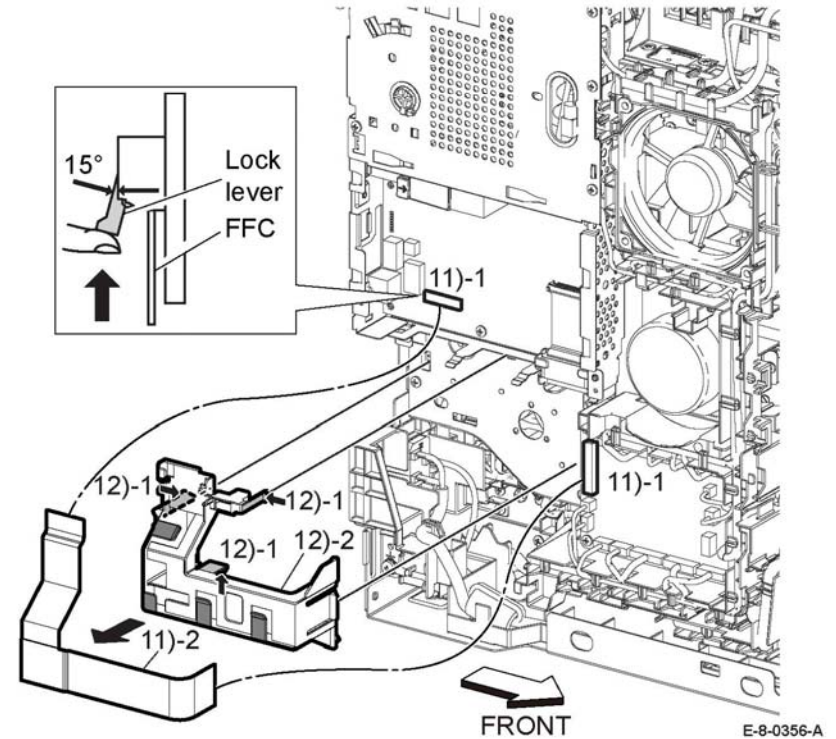
11. Perform the items that follow, Figure 3:
  - 11-1 Disconnect connectors P/J300, P/J335.
  - 11-2 Remove the ESS MCU FCC cable.
12. Perform the items that follow, Figure 3:
  - 12-1 Release three hooks.
  - 12-2 Remove the ESS MCU FCC.

Figure 3 Remove the ESS MCU FCC.

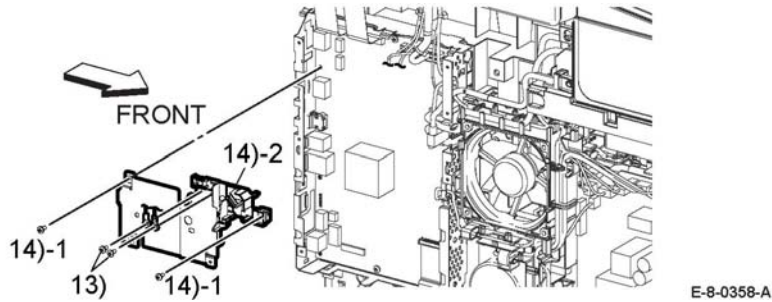
12. Remove the ESS FFC MCU, [REP 18.2](#).
13. Remove the two screws (silver, M3x6mm) attaching the earth cable to the FAX plate, [Figure 1](#).
14. Perform the items that follow, [Figure 1](#):
  - 14-1 Remove two screws (SM18).
  - 14-2 Remove the FAX plate assembly.

**Figure 1 Remove the FAX plate**

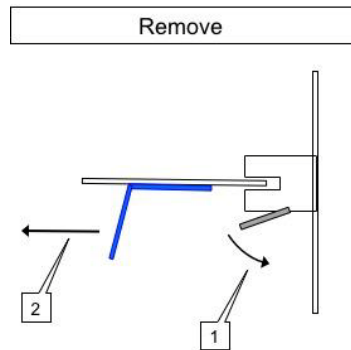
*NOTE: When engaging the release lever on the FFC connector, slightly open the release lever no more than 15 degrees. Hold the lever while gently removing the FFC from the connector as shown in [Figure 2](#).*

**Figure 2 Removal**

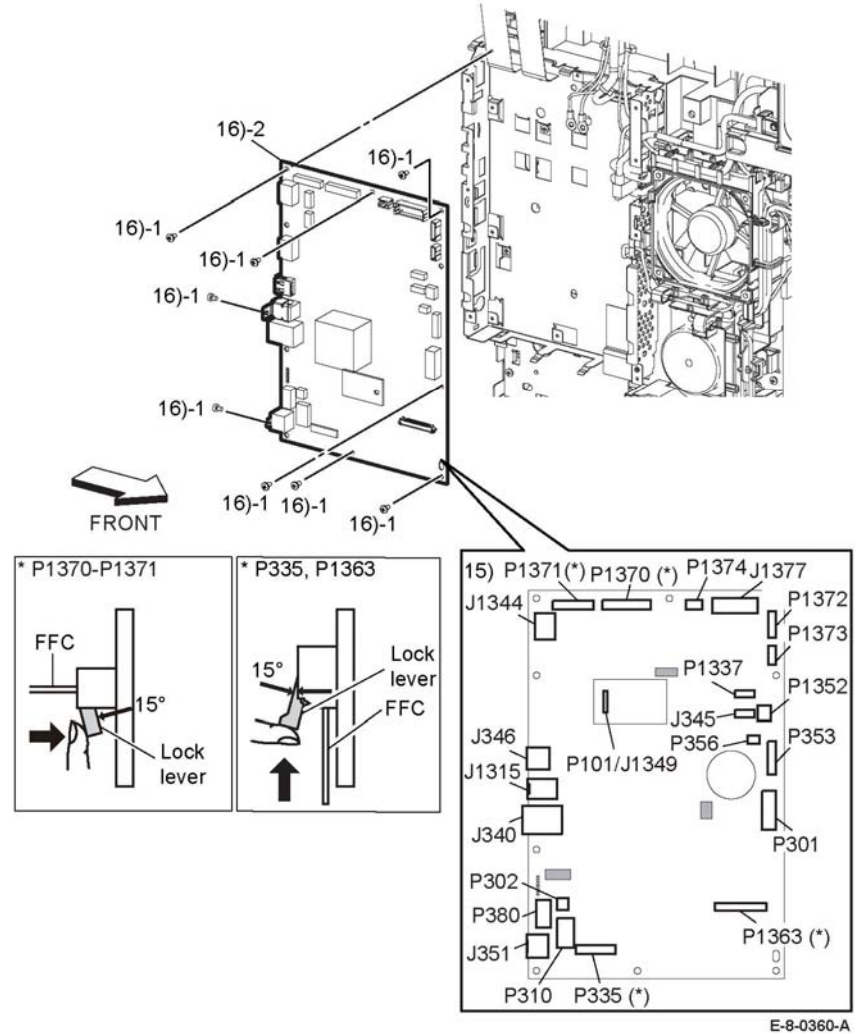
- 16-1 Remove six screws (SM18) and two screws (SM1).
- 16-2 Remove the MFP ESS PWB.

**Figure 3 Remove the PWB ESS.**

15. Disengage the connectors, P/J301, P/J345, P/J1337, P/J1352, and the FFCs P/J335, P/J1363, [Figure 3](#).
16. Perform the items that follow, [Figure 3](#):
17. **Disconnect all Cables**, carefully move the harnesses out of the way and remove the ESS PWB from the frame leaving all harnesses and guides in-place, [Figure 4](#).

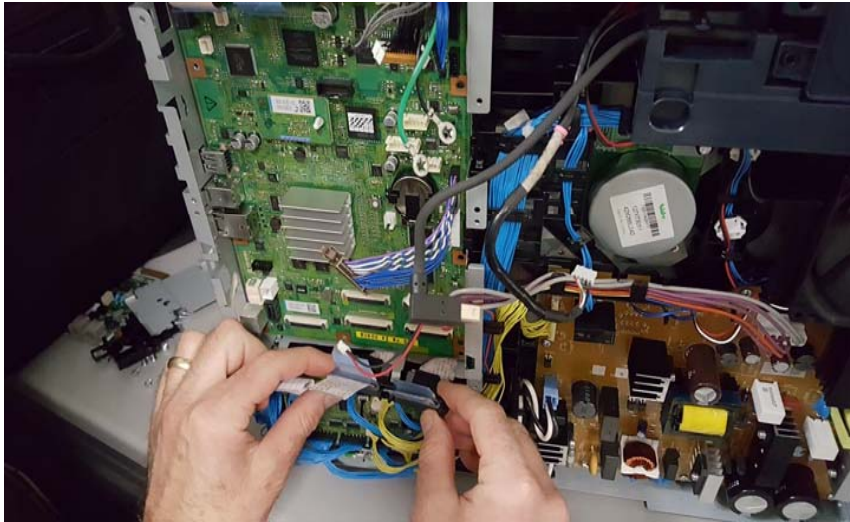
Figure 4 Disconnect all Cables

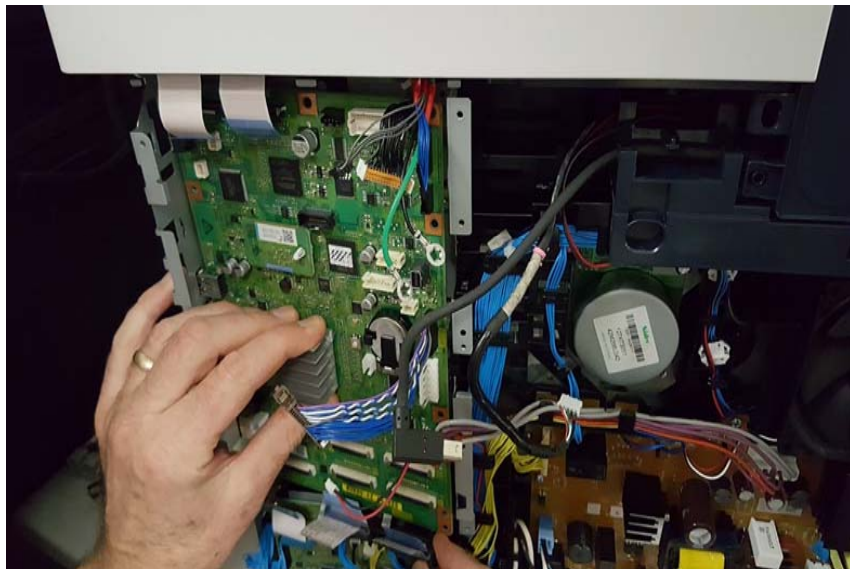
18. Lift the Bottom Right Corner from the ESS Frame, carefully ease the ESS PWB from the ESS Frame, Figure 5.

Figure 5 Lift the Bottom Right Corner from the ESS Frame

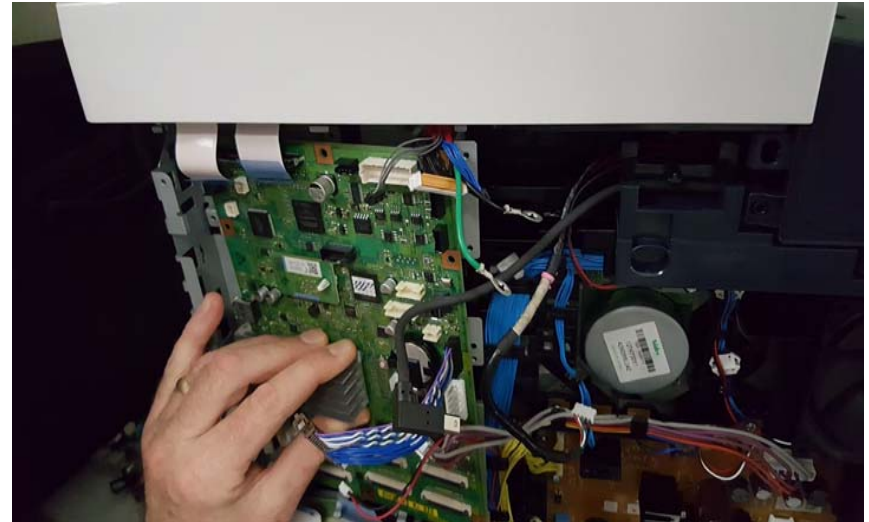
19. Slide the ESS PWB from the Right Side of the ESS Frame, carefully ease the ESS PWB out of the ESS Frame, Figure 6.

Figure 6 Slide the ESS PWB from the Right Side of the ESS Frame

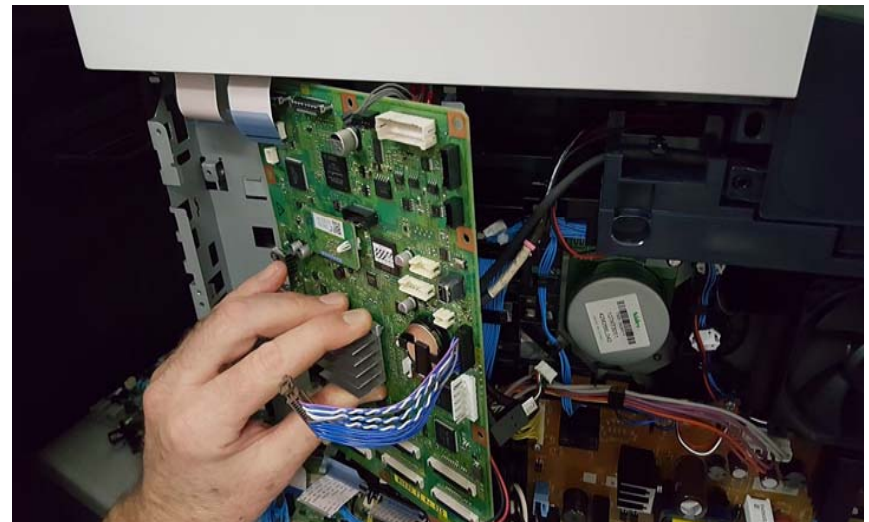
20. Slide the ESS PWB Out of the ESS Frame, to remove the ESS PWB from the ESS Frame entirely, Figure 7.

Figure 7 Remove the ESS PWB from the ESS Frame

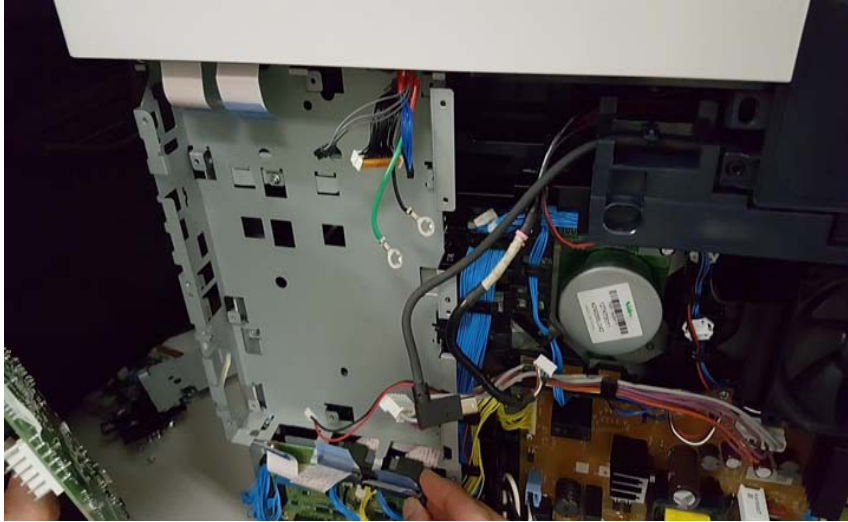
21. The ESS PWB removal is complete. **Removal Complete with FCC Guides Remaining In-place**, Figure 8

Figure 8 Removal Complete with FCC Guides Remaining In-place

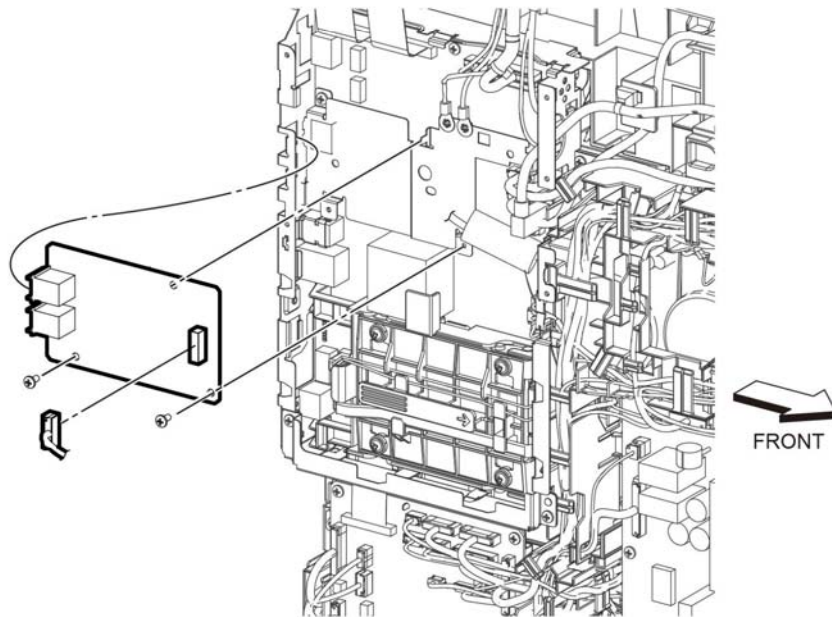
D-8-0001-A

1. Remove the left side cover, [PL 19.2 Item 2](#).
2. Remove the ESS Top plate, [PL 18.1 Item 18](#).
3. Unplug the connector (P/J1350) from the FAX PWB.
4. Refer to [Figure 1](#), to remove the two screws (silver, M3x6mm) attaching the FAX PWB.

Figure 1 Remove the FAX PWB

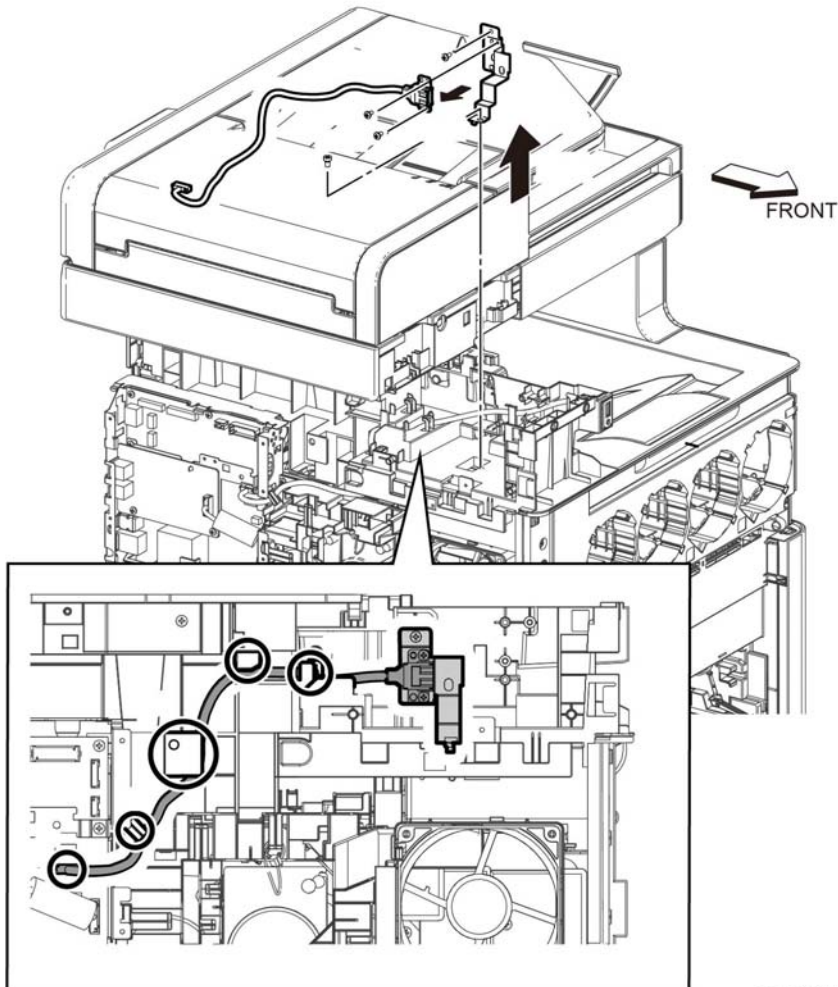
D-8-0180-A

1. Remove the UI harness, [PL 1.1 Item 5](#).
2. Unplug the connector (P/J1337).
3. Refer to [Figure 1](#), release the front USB harness assembly, [PL 18.1 Item 14](#), from the DC guide harness, [PL 18.3 Item 9](#), and the guides on the top cover, [PL 19.1 Item 15](#).
4. Refer to [Figure 1](#), remove one screw (SM3, silver, M4X6mm), and one screw (ST20, screw for plastic, silver, tapping, M3x8) to remove the front USB harness assembly and the USB bracket, [PL 18.1 Item 32](#), from the top cover.
5. Release the Front USB Harness from the harness guide.
6. Refer to [Figure 1](#), remove one screw (SM18, silver, M3X6mm) to remove the front USB harness assembly from the USB bracket.

Figure 1 Remove the USB ICCR harness assembly

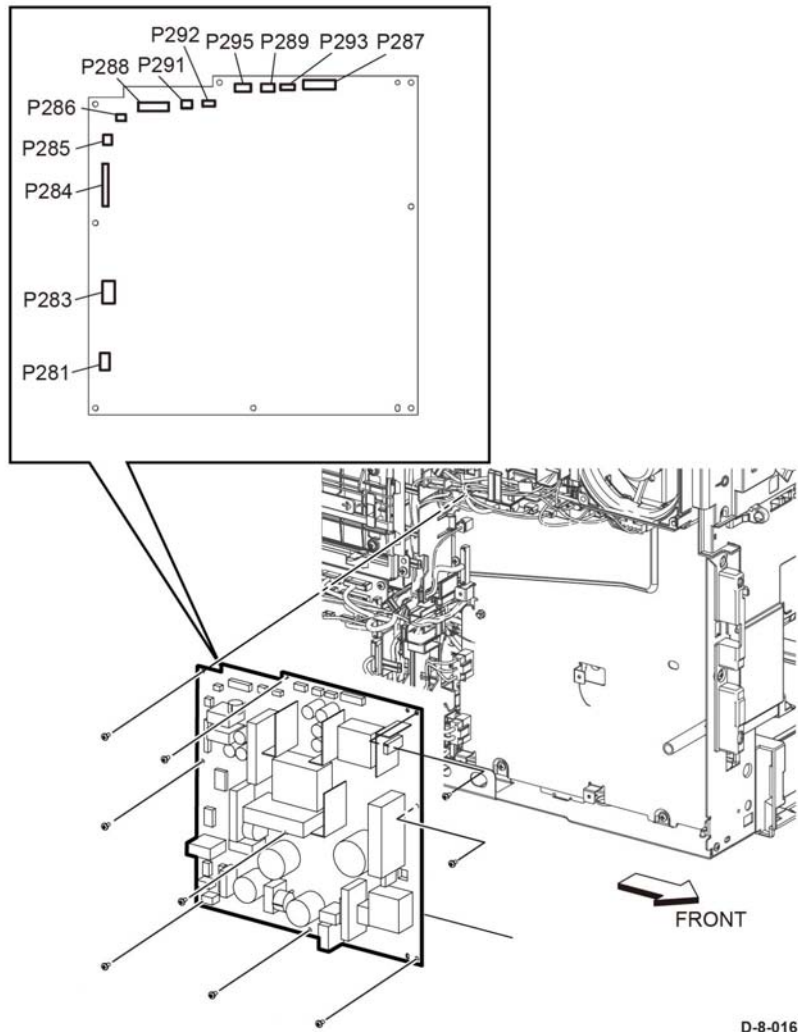
Figure 1 Remove the LVPS PWB

When replacing the LVPS PWB, be sure to place the holes in the board's upper and lower right corners onto the alignment tabs before inserting any screws.

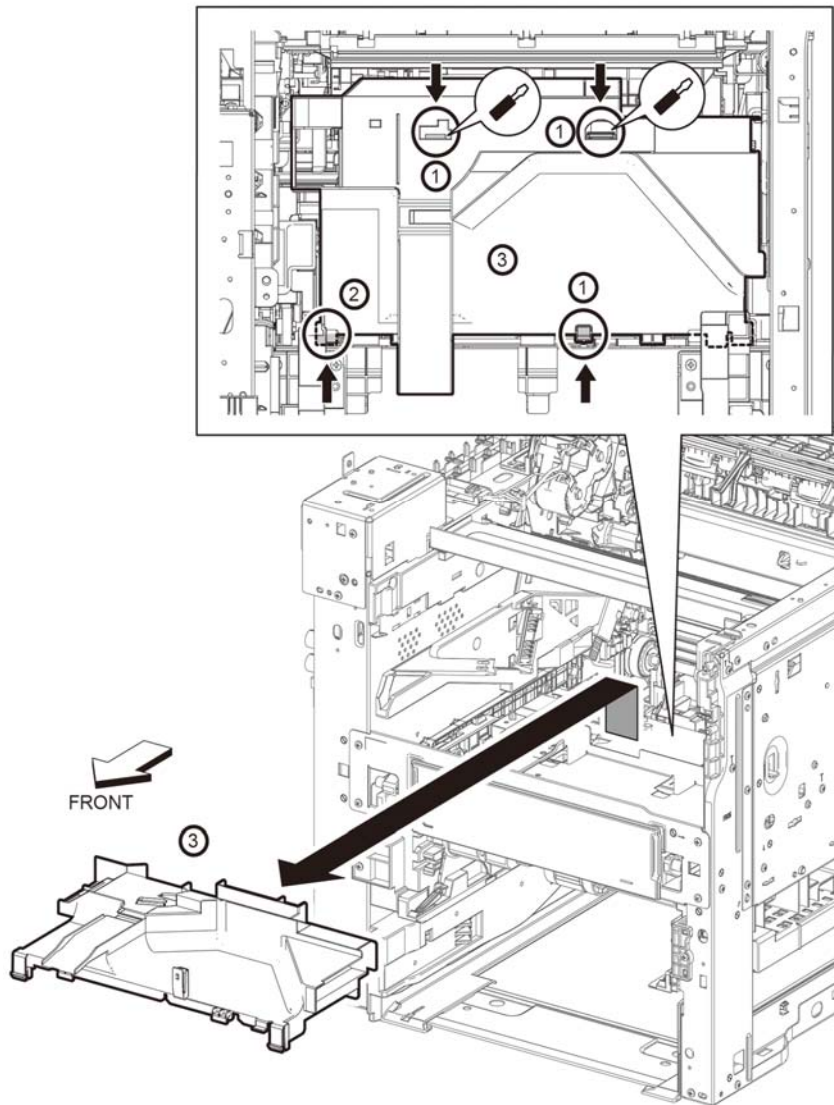
D-8-0165-B

1. Remove the LPH mono head assembly, [REP 2.1](#).
2. Remove the HVPS cover, [Figure 1](#):
  - a. Release three hooks (1), on the front side of the HVPS cover.
  - b. Release one hook (2), on the back side of the HVPS cover, then remove the HVPS cover (3).

Figure 1 HVPS cover removal

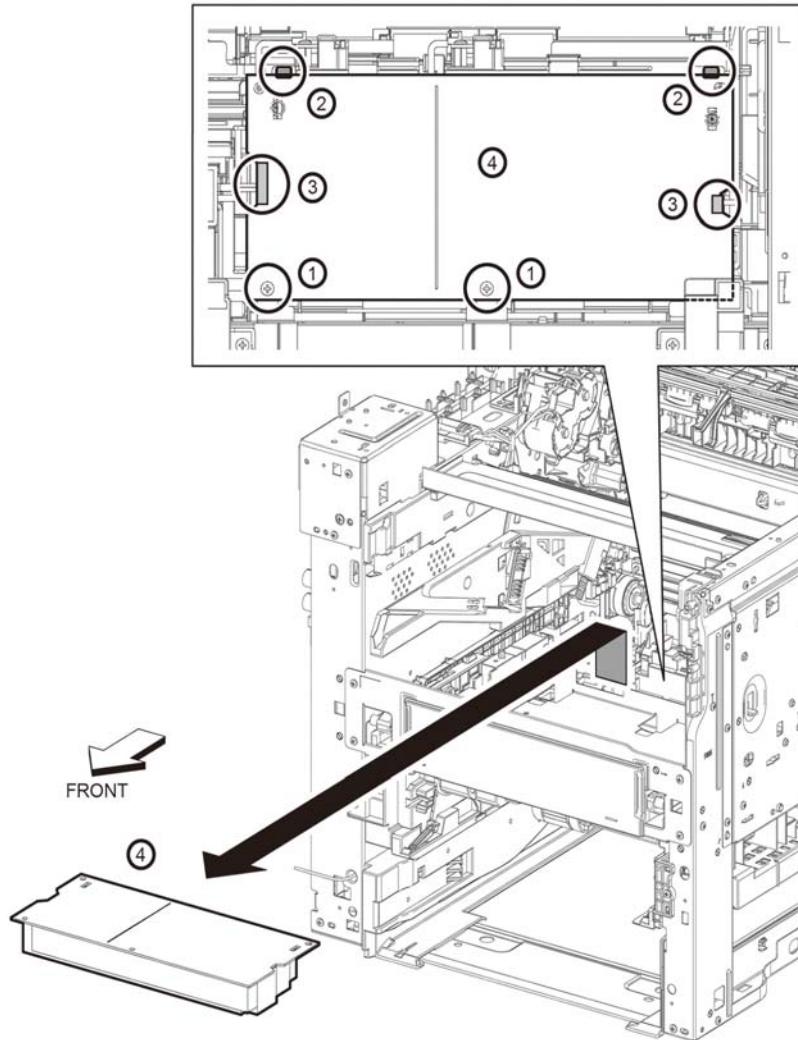
Figure 2 HVPS PWB removal

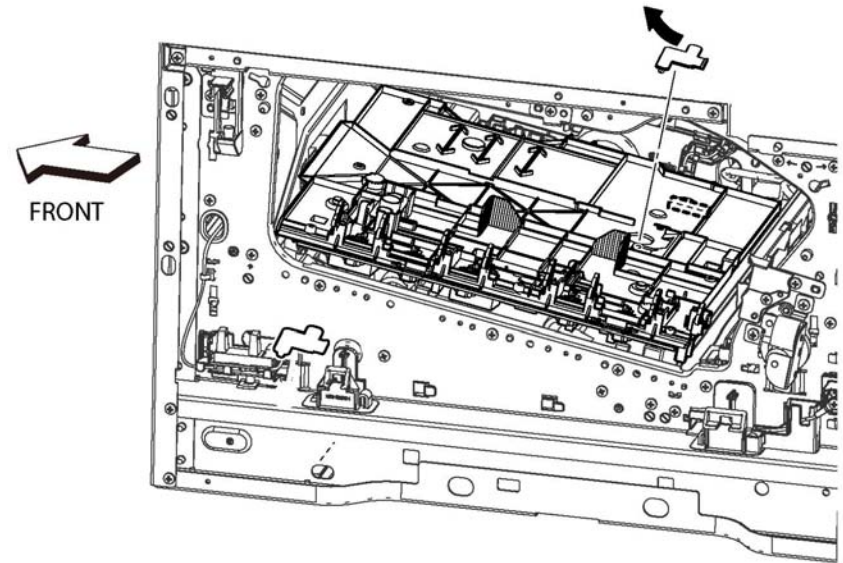
1. Remove the drum cartridge, [PL 8.1](#).
2. Remove the HVPS toner cover, [PL 18.2 Item 3](#), from the HVPS PWB, [Figure 1](#).

Figure 1 HVPS toner cover removal

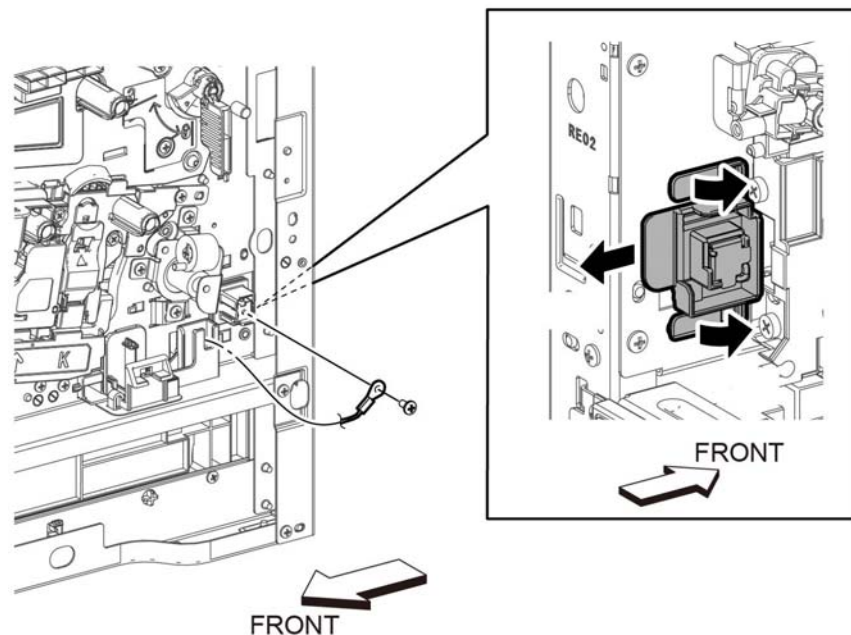
D-8-0167-A

1. Remove the right Side cover, [PL 19.1 Item 2](#).
2. Open the rear door, [PL 19.2 Item 99](#).
3. Refer to [Figure 1](#), to remove the one screw (silver, M3x6mm) attaching the high voltage harness.
4. Refer to [Figure 1](#), to release the two hooks and remove the second bias transfer housing the housing.

Figure 1 Remove the second bias transfer housing

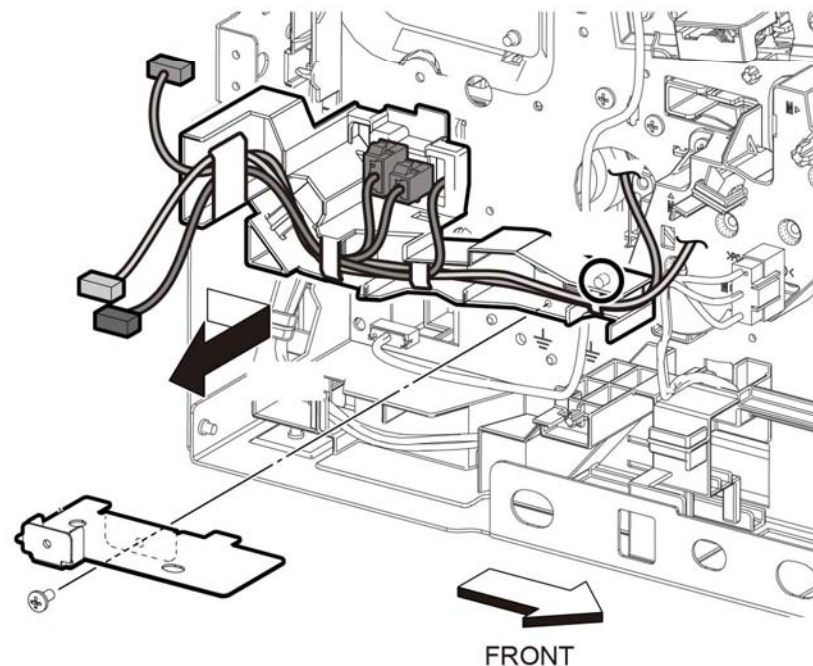
D-8-0181-A

1. Remove the exit chute assembly, [PL 17.1 Item 1](#) (C505/C605), (C500/C600).
2. Refer to [Figure 1](#), release one boss of the harness guide, and slightly release the harness guide with the harnesses in the direction of the arrow.
3. Refer to [Figure 1](#), remove one screw (SM18, silver, M3X6mm) to remove the plate.

Figure 1 Remove the AC fusing harness guide.

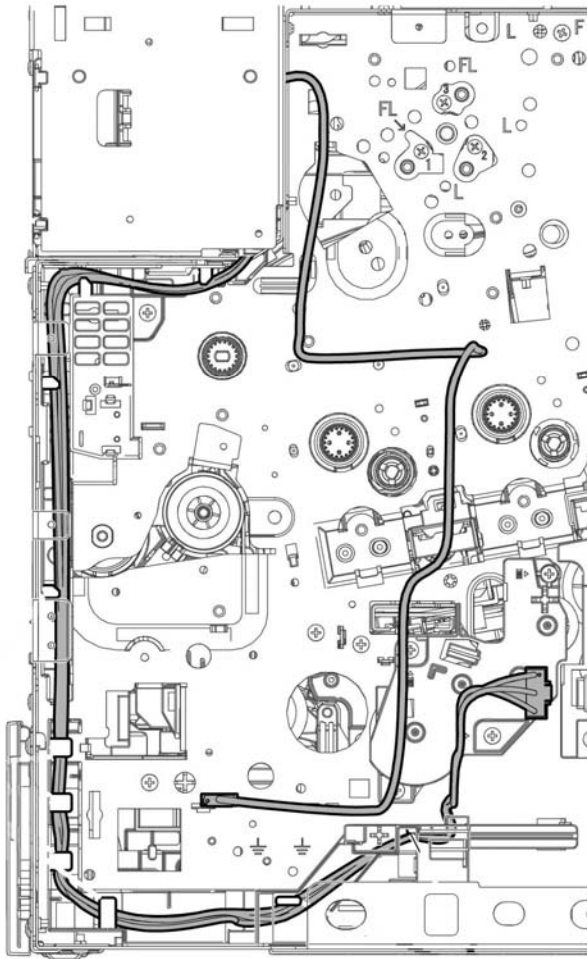
D-8-0182-A

4. Refer to [Figure 2](#), release the AC fusing harness assembly, [PL 18.3 Item 3](#), from the harness guides.

**Figure 2 Release the AC fusing harness assembly.**

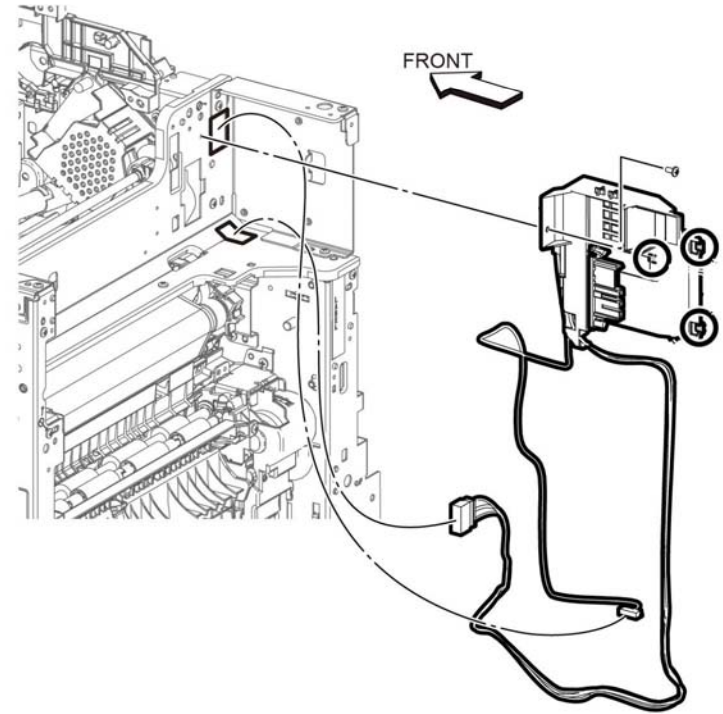
D-8-0183-A

5. Refer to [Figure 3](#), remove one screw (SM18, silver, M3X6mm), and release three hooks to remove the DC-CF fusing harness assembly, [PL 18.3 Item 2](#), and AC fusing harness assembly, [PL 18.3 Item 3](#), with the fusing harness guide, [PL 18.3 Item 4](#).

**Figure 3 Remove AC fusing harness assembly with the fusing harness guide.**

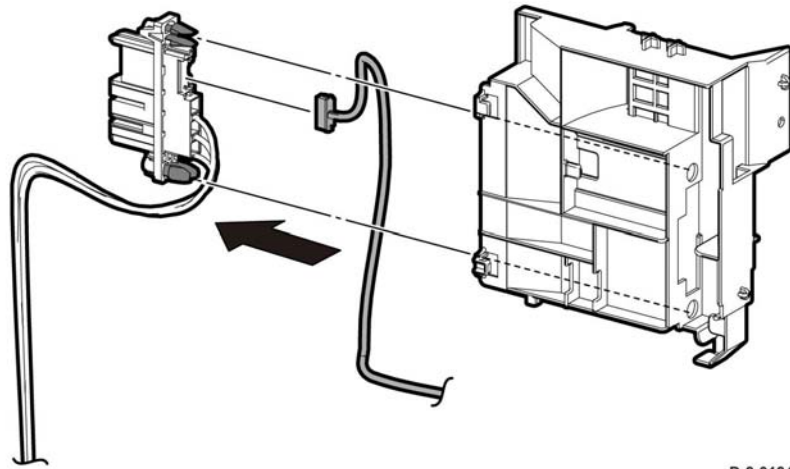
D-8-0184-A

Figure 4 Remove the DC-CF fusing harness assembly

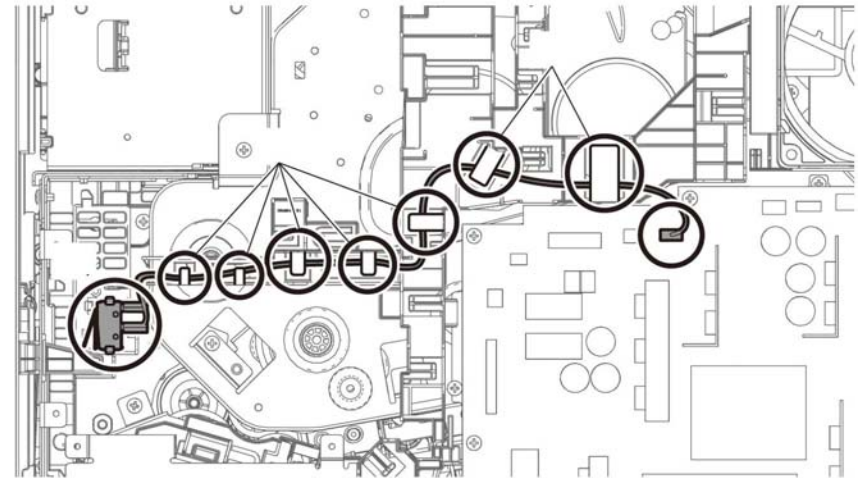
D-8-0369-A

1. Remove the AIO ESS Box, [PL 18.1 Item 15](#).
2. Refer to [Figure 1](#), unplug the connector (P/J292) from the LVPS PWB and release the cable from the cable guide.
3. Release the Rear-CF I/L harness assembly, [PL 18.3 Item 4](#), from the DC harness guide, [PL 18.3 Item 9](#), and the Rear-CF I/L Harness guide, [PL 18.3 Item 11](#).
4. Refer to [Figure 1](#), release the two hooks and remove the rear interlock harness assembly.

Figure 1 Remove the Rear Interlock harness assembly

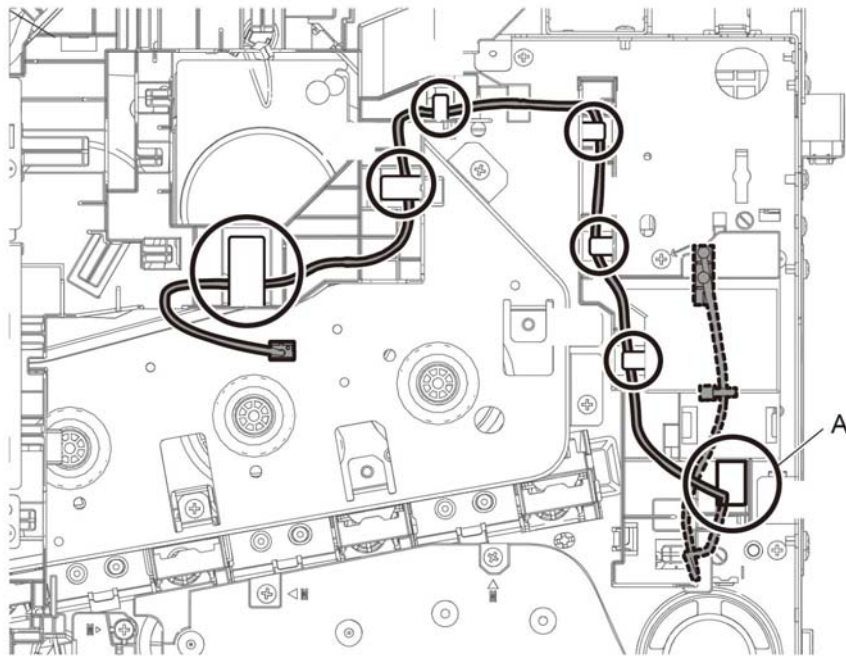
D-8-0169-A

1. Remove the LVPS plate, [PL 18.1 Item 13](#).
2. Refer to [Figure 1](#), release the Side-CF I/L harness assembly, [PL 18.3 Item 5](#), from the DC harness guide, [PL 18.3 Item 9](#), and the duct harness guide, [PL 18.3 Item 10](#).
3. Refer to [Figure 1](#), pull out the Side-CF I/L harness assembly from the hole A.

Figure 1 Release the Side Interlock Harness from the Hooks

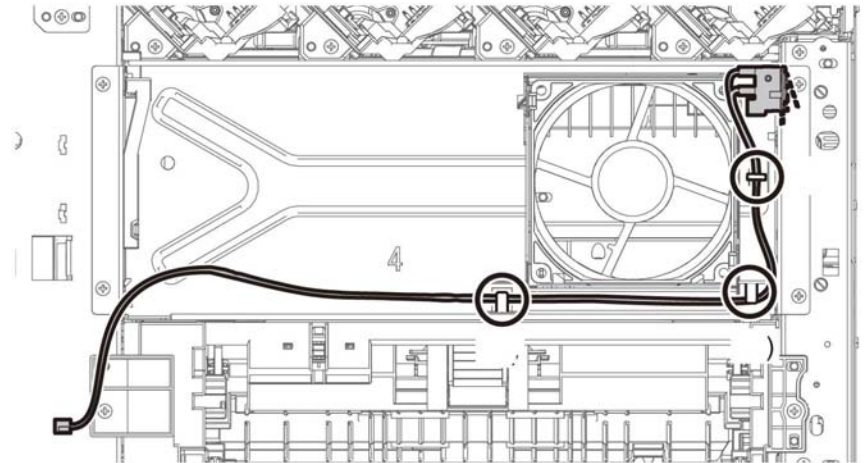
D-8-0170-A

4. Refer to [Figure 2](#), release the Side-CF I/L harness assembly from the sub fan duct, [PL 4.1 Item 4](#).
5. Refer to [Figure 2](#), remove the Side-CF I/L harness assembly from one push-tie of the sub fan duct.

Figure 2 Remove the Side interlock harness assembly

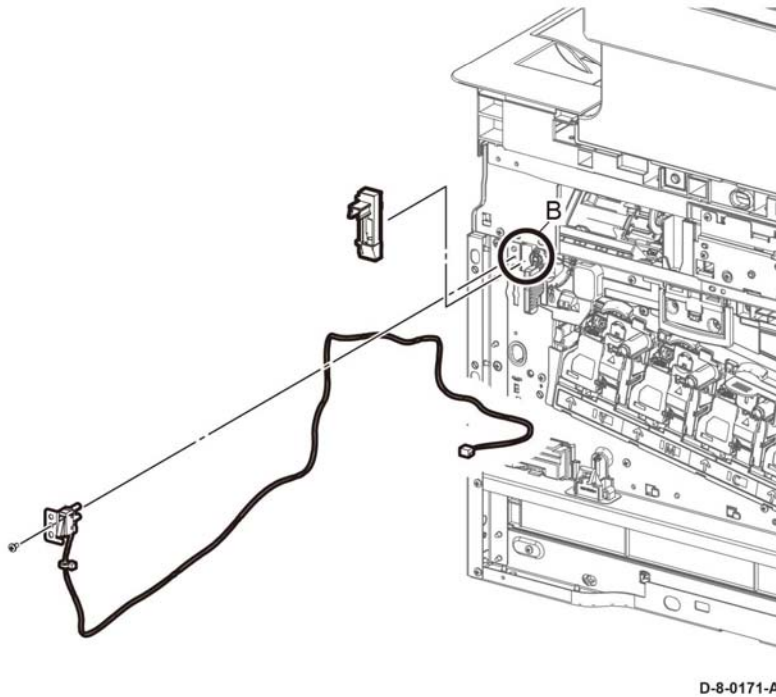
Figure 3 Pull out the Side-CF I/L harness assembly from the hole B.

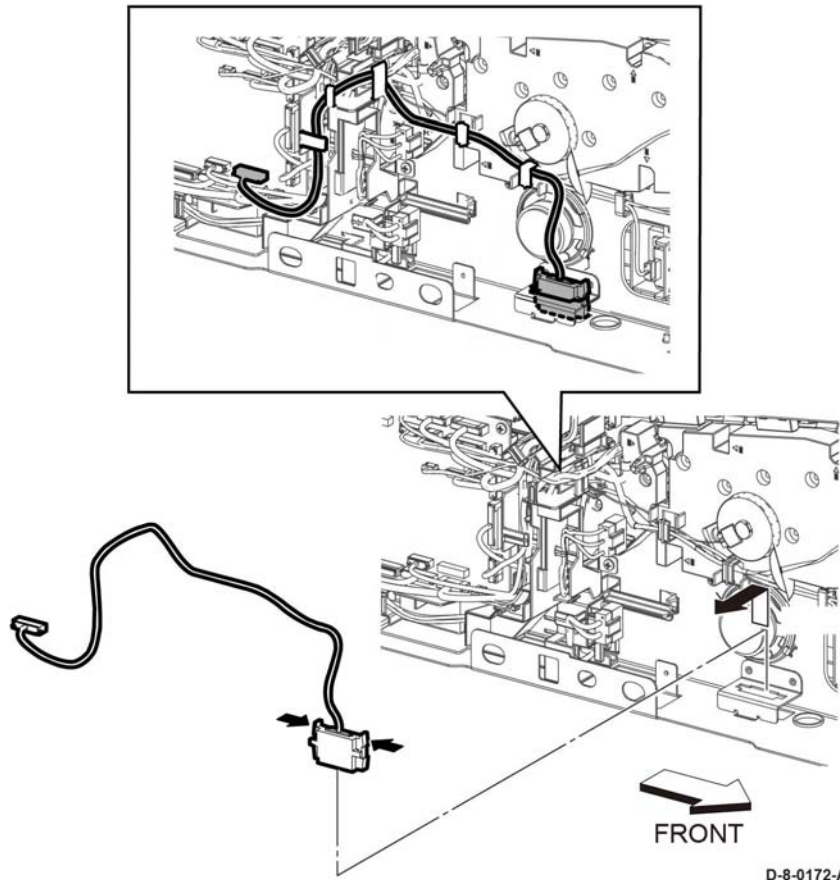
2. Refer to [Figure 1](#), unplug the connector (P/J800) and release the harness portion of the OPF-CF harness assembly from the four hooks of the harness guide.
3. Refer to [Figure 1](#), push the two hooks on the OPF-CF harness assembly and remove the OPF-CF harness assembly.

Figure 1 Remove the OPF harness assembly

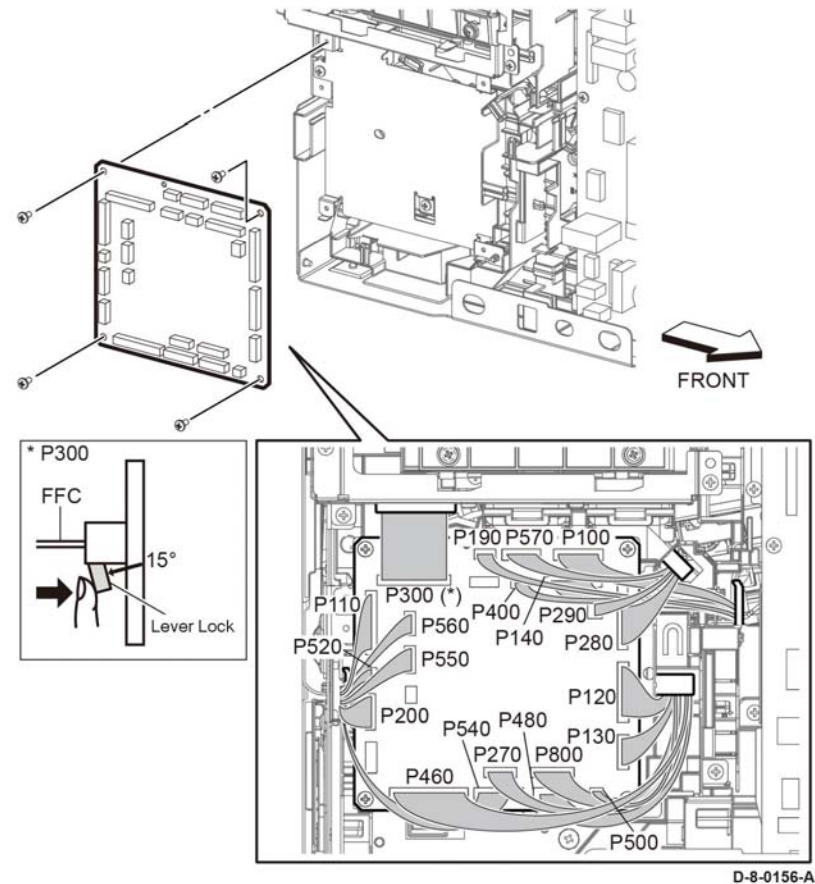
2. Refer to Figure 2, unplug connectors (P/J100, P/J110, P/J120, P/J130, P/J140, P/J190, P/J200, P/J220, P/J270, P/J280, P/J290, P/J400, P/J460, P/J480, P/J500, P/J520, P/J540, P/J550, P/J560, P/J570, P/J800) and the FFC (P/J300).
3. Refer to Figure 2, remove four screws (silver, M3x6mm) securing MCU PWB, PL 18.5 Item 1, and remove the MCU PWB.

Figure 2 Remove the MCU PWB
