# VersaLink® B600/B610 Printer and B605/B615 Multifunction Printer Service Manual

Xerox® VersaLink® B600 Family MFP Service Manual

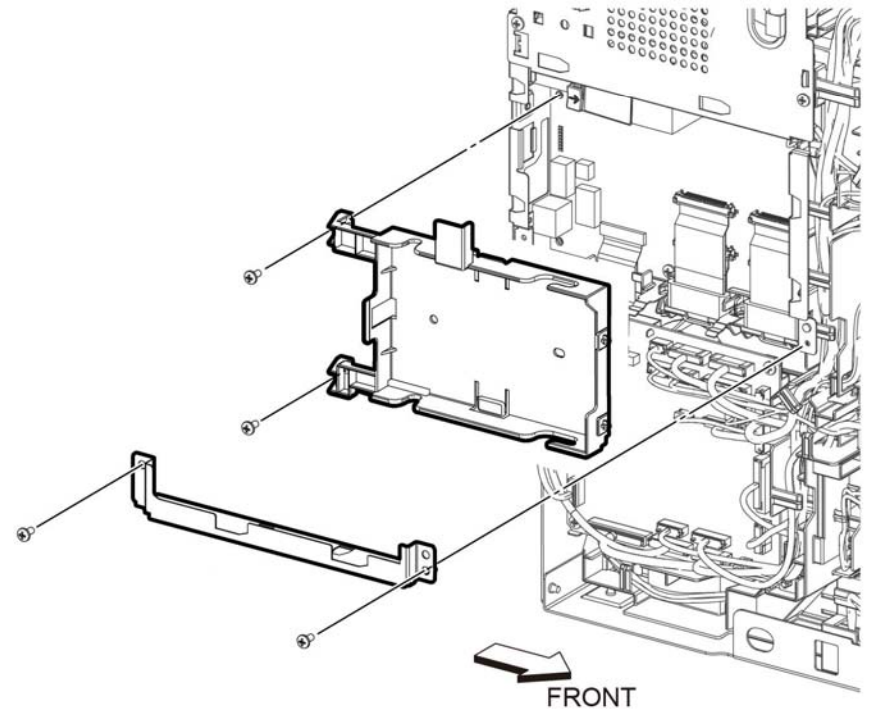
- Remove the left side cover, [PL 19.2 Item 1](#).
- Refer to [Figure 1](#), remove two screws (silver, M3x6mm) attaching the ESS Lower plate and remove the plate.
- Refer to [Figure 1](#), remove two screws (SM18, silver, M3X6mm) and remove HDD bracket, [PL 18.1 Item 28](#).

Figure 1 Remove the HDD bracket (MFP Tall)

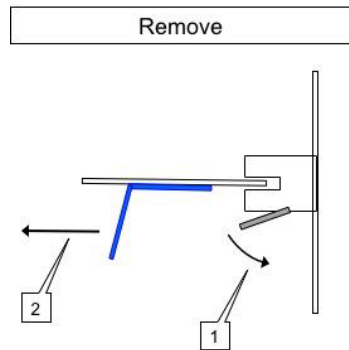
NOTE: When engaging the release lever on the FFC connector, slightly open the release lever no more than 15 degrees. Hold the lever while gently removing the FFC from the connector as shown in Figure 2.

Figure 2 Removing the FFC from the connector.

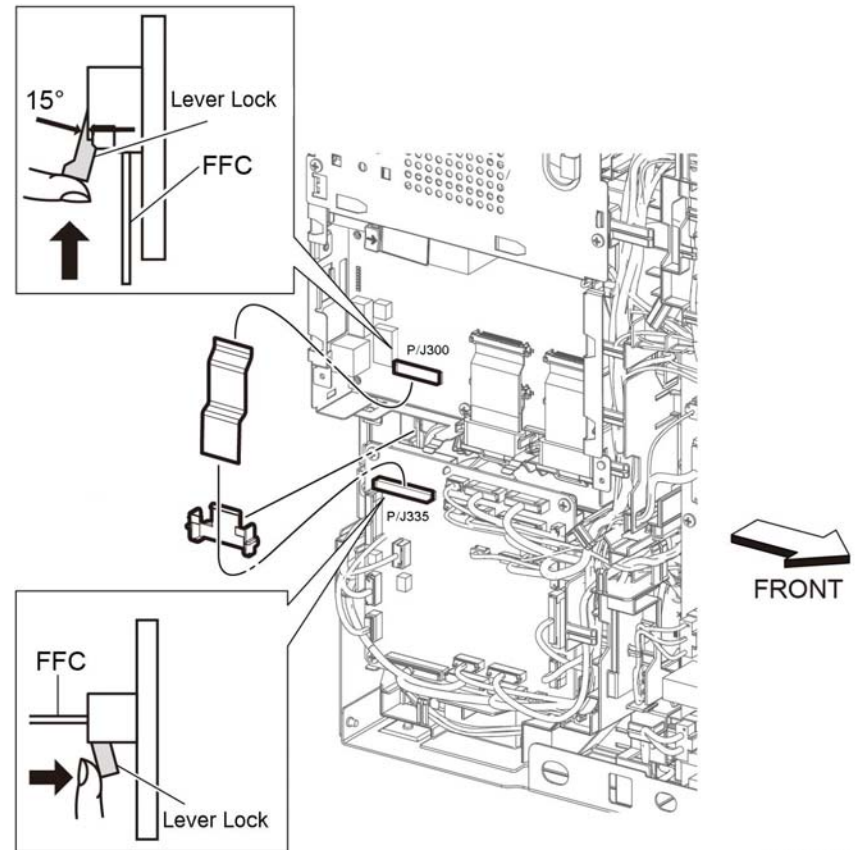
4. Unplug connectors (P/J300, P/J335) and remove the ESS MCU FCC.

Figure 3 Remove the ESS MCU FCC

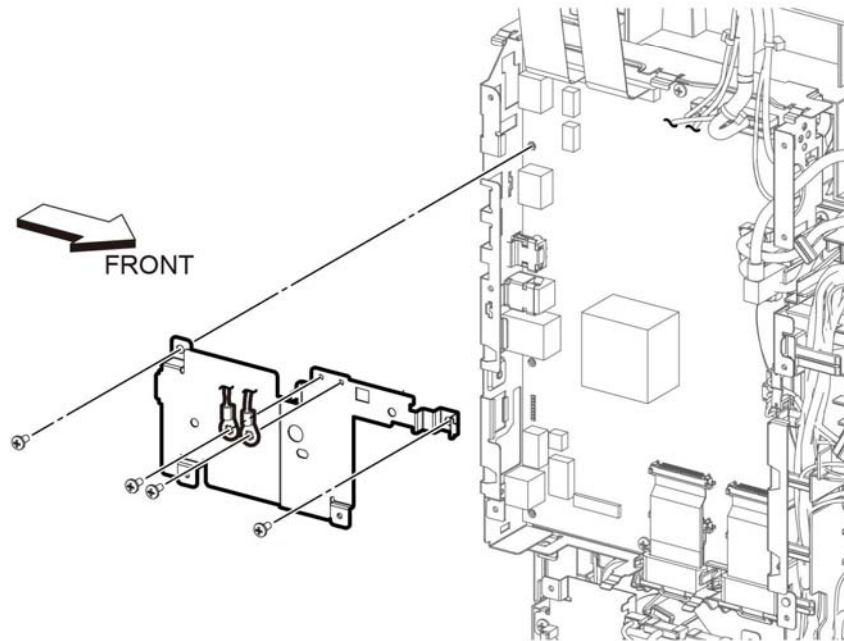
D-8-0159-A

- Remove the FAX PWB, [PL 18.1 Item 9](#).
  - Remove the Guide FFC Color MCU [PL 18.1 Item 7](#).
  - Refer to [Figure 1](#), to remove the two screws (silver, M3x6mm) attaching the earth cable to the FAX plate, [PL 18.1 Item 9](#).

- Remove the three screws (silver, M3x6mm) attaching the FAX plate, [PL 18.1 Item 6](#) and remove the FAX plate.

Figure 1 Remove the FAX plate (MFP Tail)

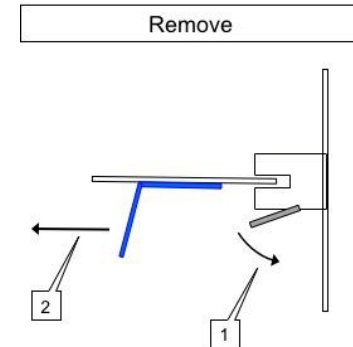
NOTE: When engaging the release lever on the FFC connector, slightly open the release lever no more than 15 degrees. Hold the lever while gently removing the FFC from the connector as shown in Figure 2.

Figure 2 Removing the FFC from the connector

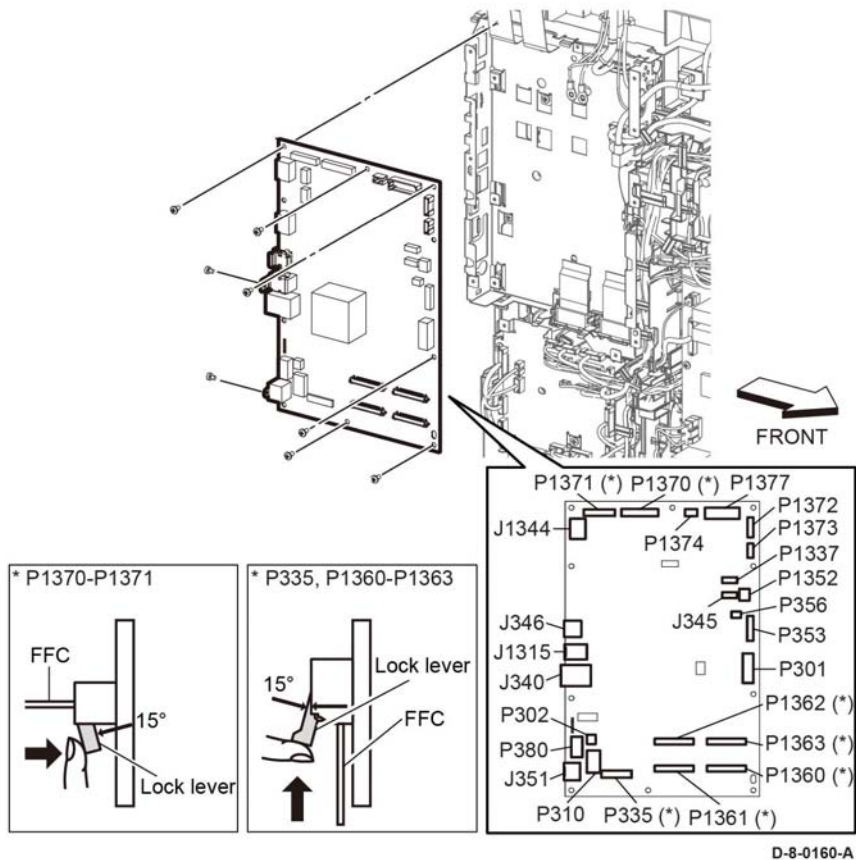
5. Refer to Figure 3, disengage the connectors (P/J301, P/J345, P/J356, P/J1337, P/J1352, P/J1372, P/J1373, P/J1374, P/J1377) and the FFCs (P/J1360, P/J1361, P/J1362, P/J1363, P/J1370, P/J1371, P/J335).
6. Refer to Figure 3, remove six screws (SM18, silver, M3X6mm) and two screws (SM1, silver, M3Xmm) and remove the ESS PWB, PL 18.1 Item 5.

Figure 3 Remove the PWB ESS.

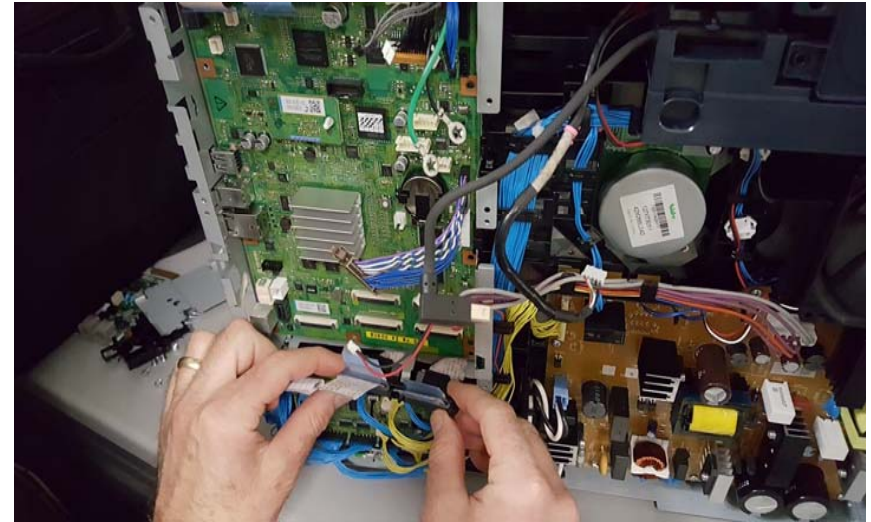
- Refer to [Figure 4](#), **Disconnect all Cables**, carefully move the harnesses out of the way and remove the ESS PWB from the frame leaving all harnesses and guides in-place.

Figure 4 Disconnect all Cables

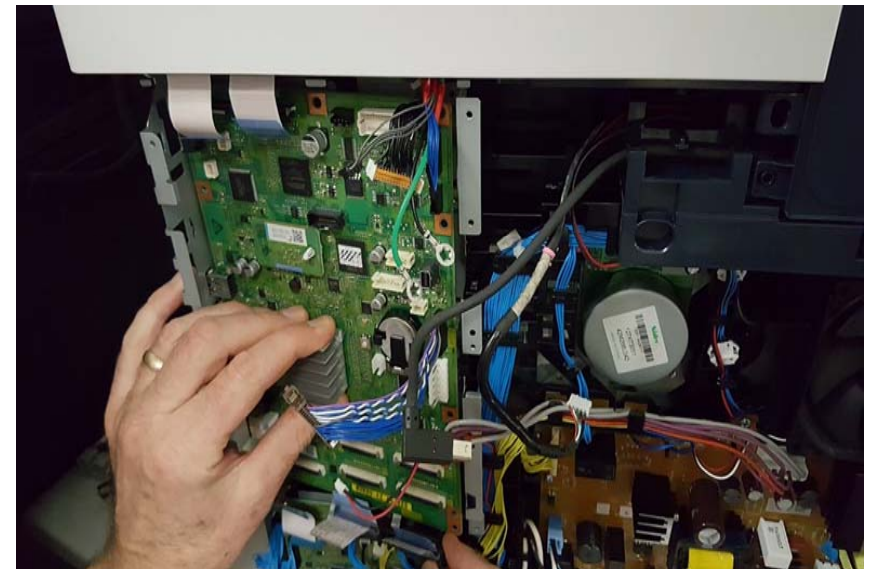
- Refer to [Figure 5](#), **Lift the Bottom Right Corner from the ESS Frame**, carefully ease the ESS PWB from the ESS Frame.

Figure 5 Lift the Bottom Right Corner from the ESS Frame

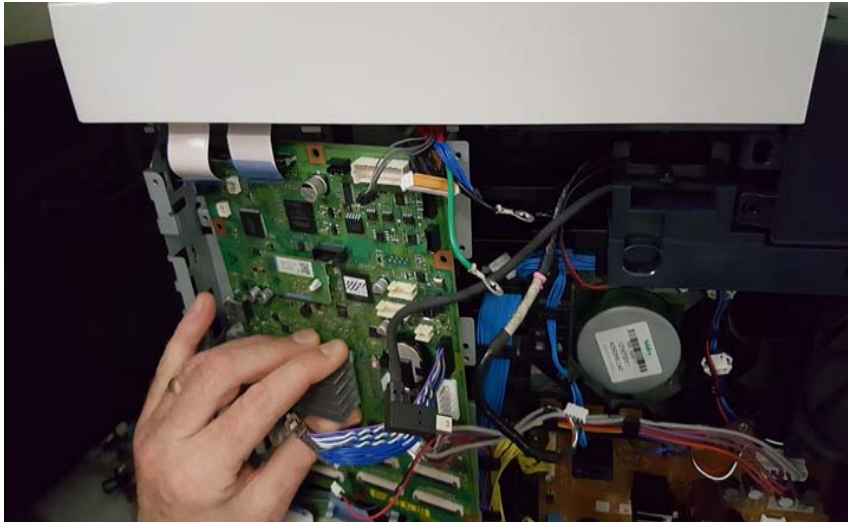
9. Refer to [Figure 6](#), **Slide the ESS PWB from the Right Side of the ESS Frame**, carefully ease the ESS PWB out of the ESS Frame.

Figure 6 Slide the ESS PWB from the Right Side of the ESS Frame

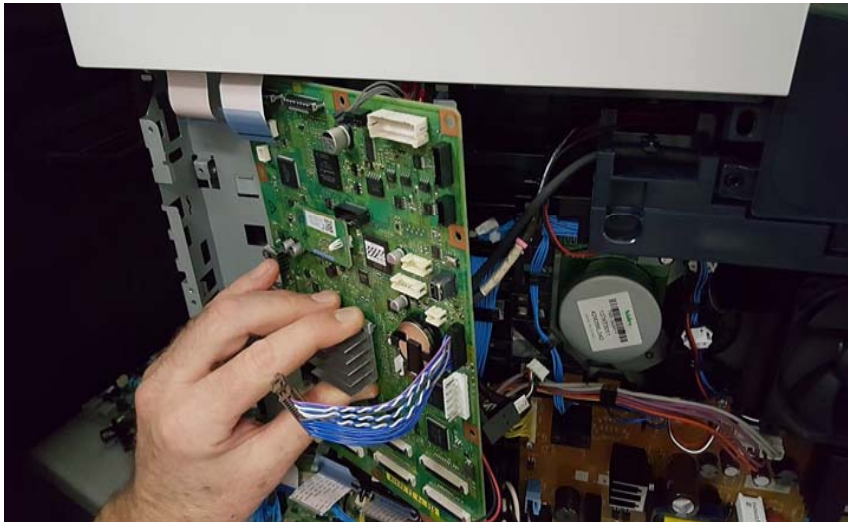
10. Refer to [Figure 7](#), **Slide the ESS PWB Out of the ESS Frame**, to remove the ESS PWB from the ESS Frame entirely.

Figure 7 Remove the ESS PWB from the ESS Frame

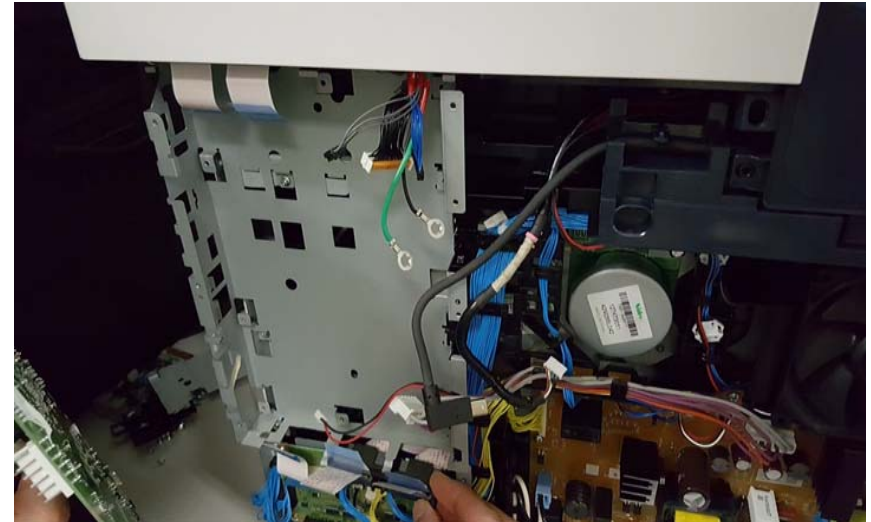
11. The ESS PWB removal is complete, [Figure 8](#), **Removal Complete with FCC Guides Remaining In-place**

Figure 8 Removal Complete with FCC Guides Remaining In-place

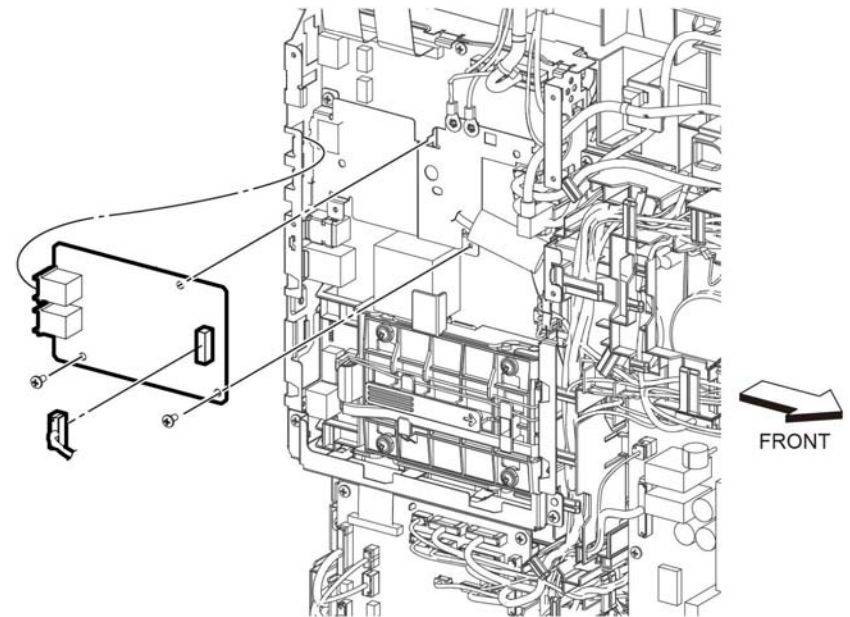
D-8-0001-A

- Remove the left side cover, [PL 19.2 Item 2](#).
- Remove the ESS Top plate, [PL 18.1 Item 18](#).
- Disconnect the connector ( [P/J1350](#)) from the FAX PWB.
- Remove the two screws (silver, M3x6mm) attaching the FAX PWB, [Figure 1](#).

Figure 1 Remove the FAX PWB (MFP Tail)

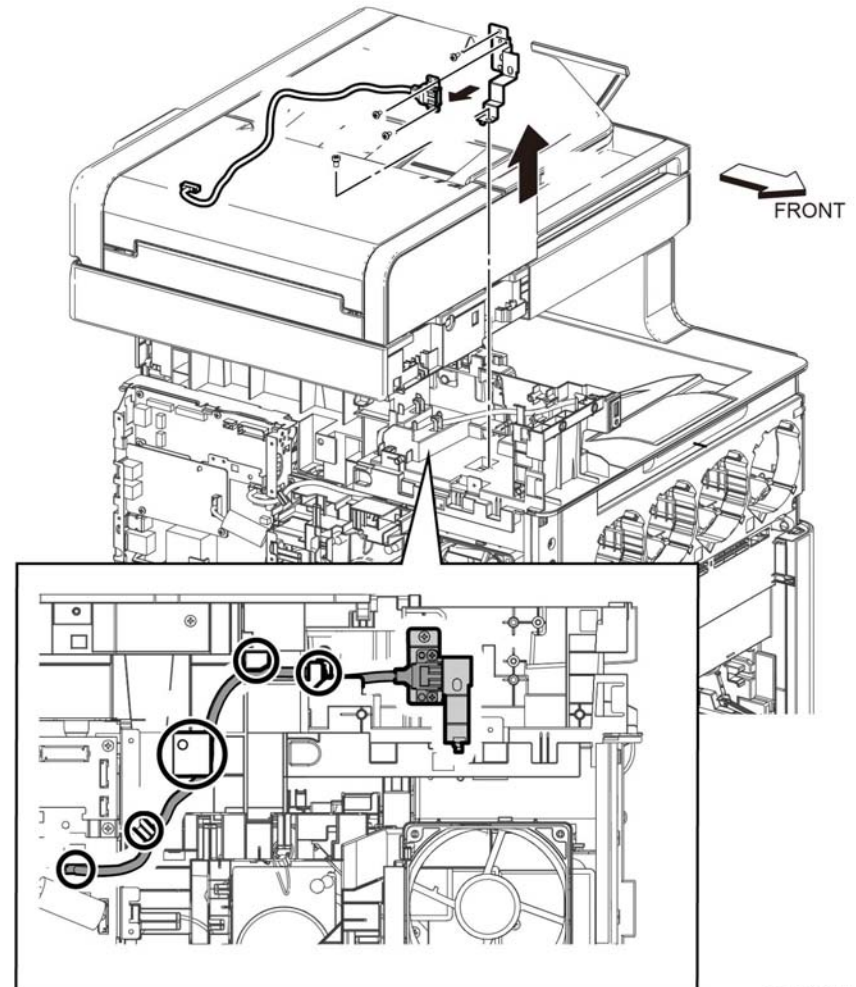
D-8-0180-A

1. Remove the UI harness, [PL 1.1 Item 5](#).
2. Disconnect the connector (P/J345).
3. Release the USB ICCR harness assembly, [PL 18.1 Item 13](#), from the DC harness guide, [PL 18.3 Item 9](#), and the guides on the top cover, [PL 19.1 Item 15](#).
4. Remove the two screws (SM3 silver M4X6mm and ST20 plastic silver M3x8) to remove the USB ICCR harness assembly and the USB ICCR bracket, [PL 18.1 Item 31](#), from the top cover, [Figure 1](#).
5. Remove two screws (SM18, silver, M3X6mm) to remove the USB ICCR harness assembly from the USB ICCR bracket, [Figure 1](#).

Figure 1 Remove the USB ICCR harness assembly (MFP Tall)

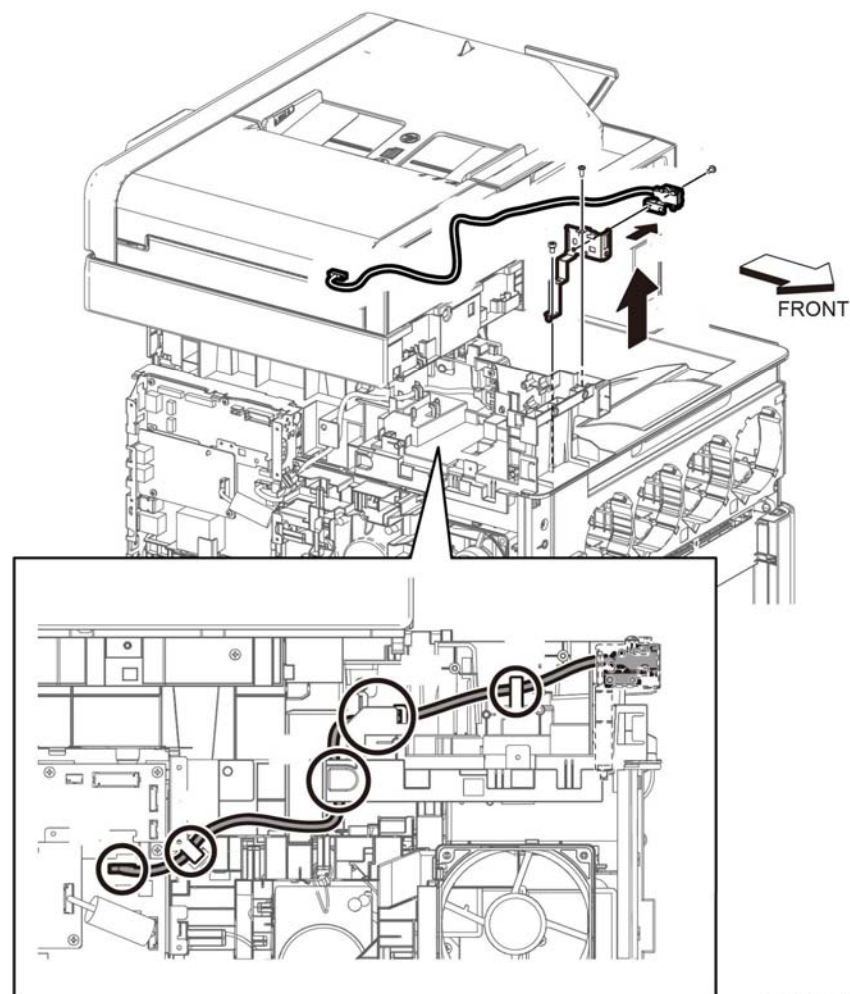
D-8-0162-A

1. Remove the UI harness, [PL 1.1 Item 5](#).
2. Unplug the connector (P/J1337).
3. Refer to [Figure 1](#), release the front USB harness assembly, [PL 18.1 Item 14](#), from the DC guide harness, [PL 18.3 Item 9](#), and the guides on the top cover, [PL 19.1 Item 15](#).
4. Refer to [Figure 1](#), remove one screw (SM3, silver, M4X6mm), and one screw (ST20, screw for plastic, silver, tapping, M3x8) to remove the front USB harness assembly and the USB bracket, PL18.1.32, from the top cover.
5. Release the Front USB Harness from the harness guide.
6. Refer to [Figure 1](#), remove one screw (SM18, silver, M3X6mm) to remove the front USB harness assembly from the USB bracket.

Figure 1 Remove the front USB harness assembly (MFP Tall)

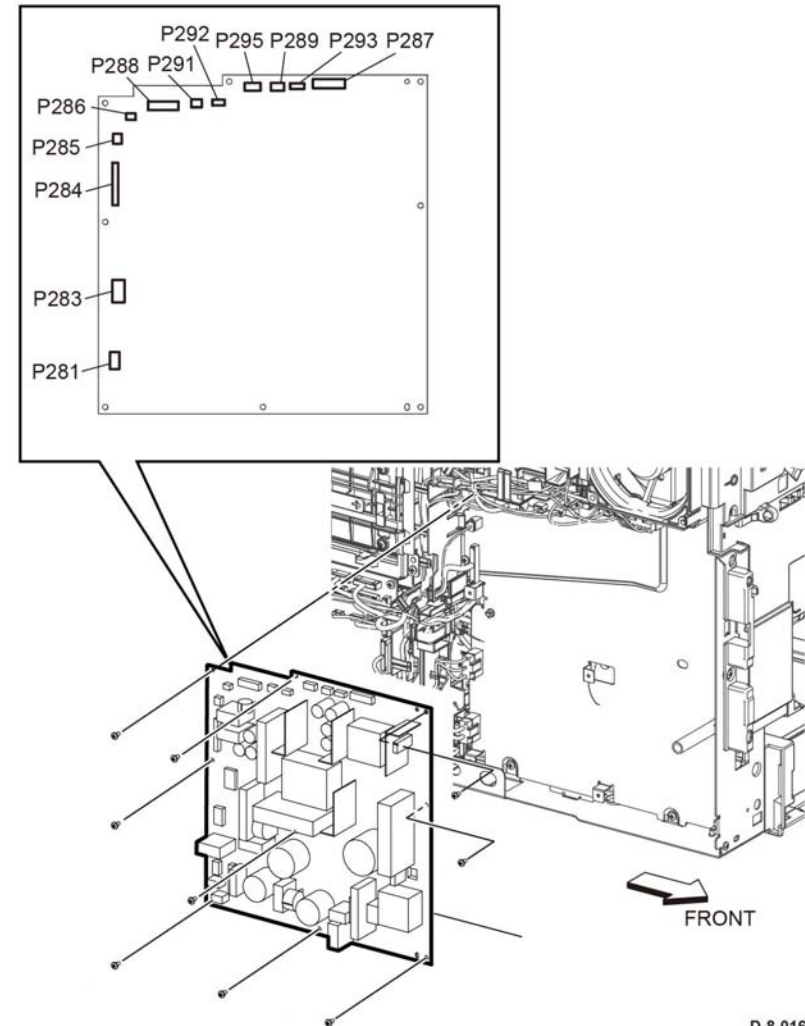
1. Remove the left side cover, [PL 19.2 Item 1](#).
2. Refer to [Figure 1](#), unplug the connectors (P/J281, P/J283, P/J284, P/J285, P/J286, P/J287, P/J288, P/J289, P/J291, P/J292, P/J293, P/J295) from the LVPS PWB.
3. Refer to [Figure 1](#), remove the seven screws (M18, silver, M3x6mm) attaching the LVPS PWB to the LVPS plate and remove the LVPS PWB.

Figure 1 Remove the LVPS PWB.

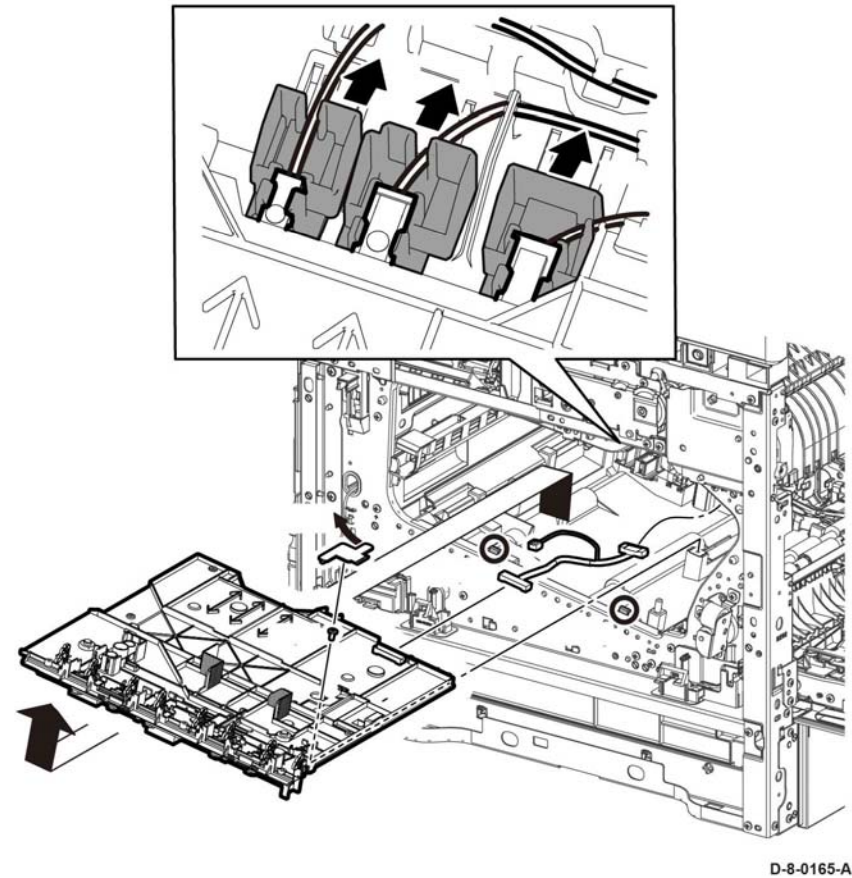
D-8-0165-A

1. Refer to [Figure 1](#), remove the HVPS guide assembly (MFP Tall), to remove the HVPS toner cover, [PL 18.1 Item 3](#).
2. Refer to [Figure 1](#), remove the HVPS guide assembly (MFP Tall), to remove the screw (silver, M3x6mm) located under the HVPS toner cover.
3. Refer to [Figure 1](#), remove the HVPS guide assembly (MFP Tall), and push the faston holders in the direction of the arrows to remove the faston terminals (P/J501, P/J502, T601).
4. Refer to [Figure 1](#), disconnect the connector, ( P/J100).
5. Refer to [Figure 1](#), release the two hooks and remove the HVPS guide assembly in the direction of the arrow.

Figure 1 Remove the HVPS guide assembly (MFP Tall)

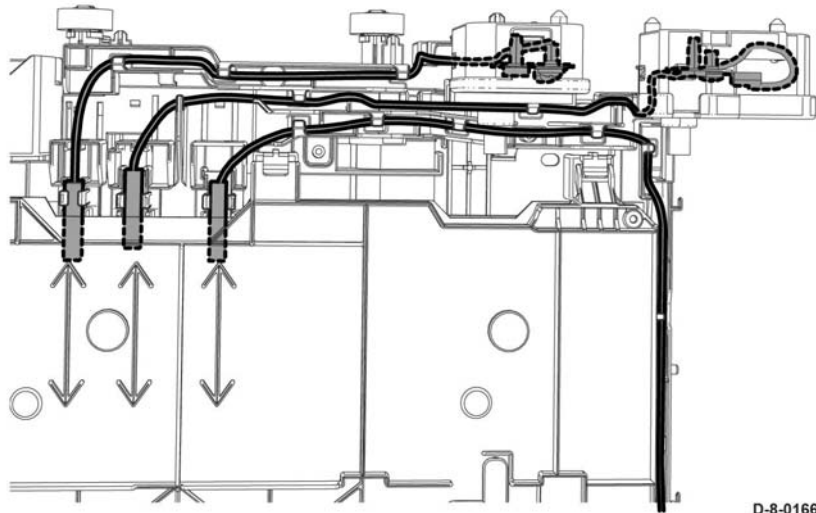
Figure 2 Re-attaching HVPS guide harnesses (MFP Tall)

1. Connect the connector P/J101.
2. Place the HVPS guide assembly into its installed position making sure to insert the alignment tabs at the left edge of the board into their slots.
3. Slide the faston connector holders towards the board to reconnect the plugs.

**NOTE:** Make sure to attach the faston connectors (P/J501, P/J502, T601: K 1st supply harness assembly, PL 18.2 Item 7, YMC 1st supply harness assembly, PL 18.2 Item 6, and trans supply harness assembly, PL 18.2 Item 8, at the initial position as shown in Figure 2.

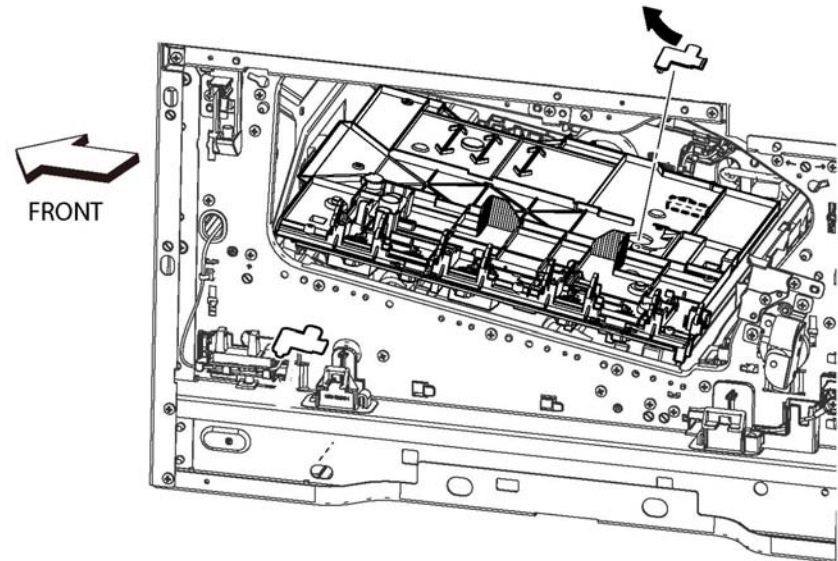
Figure 1 Remove the HVPS toner cover (MFP Tall)

1. Remove the drum cartridges Y, M, C, K, PL 8.1.
2. Refer to Figure 1, to remove the HVPS toner cover from the HVPS PWB.

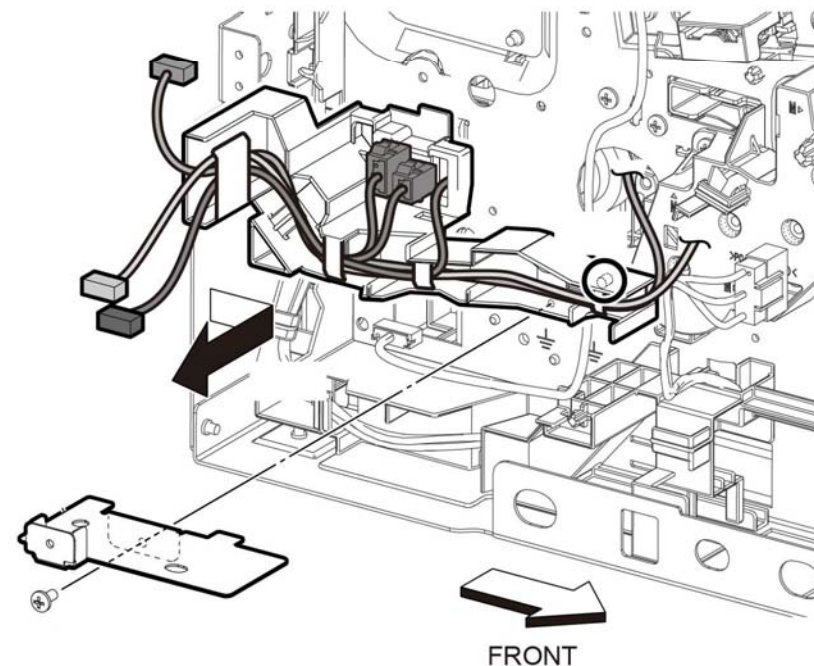
Figure 1 Remove the AC fusing harness guide.

1. Remove the exit chute assembly, [PL 17.1 Item 1](#) (C505/C605), (C500/C600).
2. Refer to [Figure 1](#), release one boss of the harness guide, and slightly release the harness guide with the harnesses in the direction of the arrow.
3. Refer to [Figure 1](#), remove one screw (SM18, silver, M3X6mm) to remove the plate.

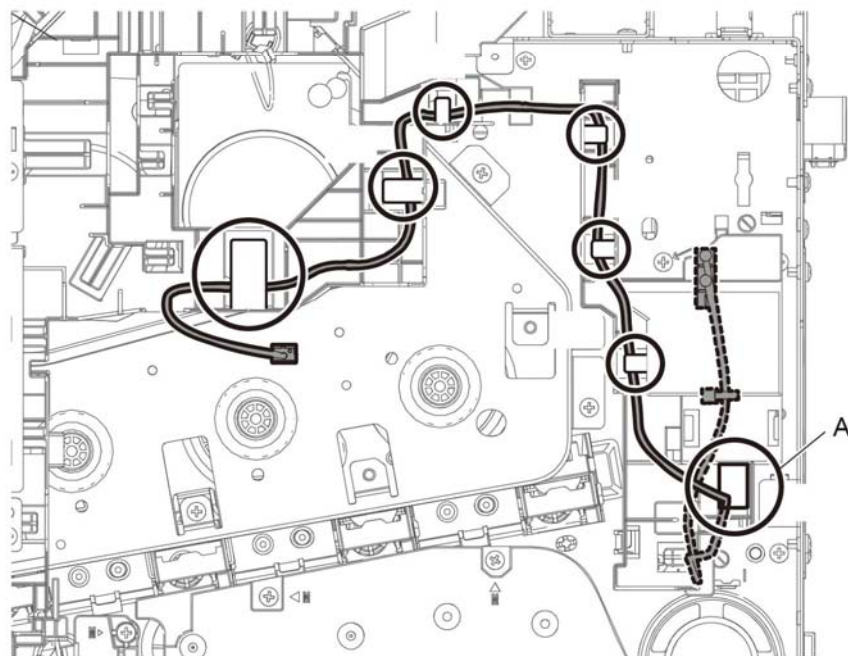
Figure 1 Side interlock harness release

1. Remove the LVPS plate, [PL 18.1 Item 13](#).
2. Refer to [Figure 1](#), release the Side-CF I/L harness assembly, [PL 18.3 Item 5](#), from the DC harness guide, [PL 18.3 Item 9](#), and the duct harness guide, [PL 18.3 Item 10](#).
3. Refer to [Figure 1](#), pull out the Side-CF I/L harness assembly from the hole A.

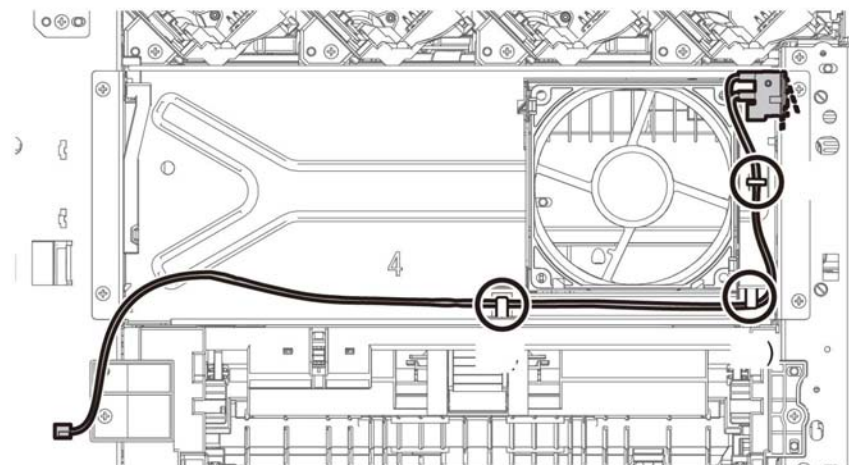
Figure 2 Side interlock harness assembly removal (MFP Tall)

4. Refer to [Figure 2](#), release the Side-CF I/L harness assembly from the sub fan duct, [PL 4.1 Item 4](#).
5. Refer to [Figure 2](#), remove the Side-CF I/L harness assembly from one push-tie of the sub fan duct.

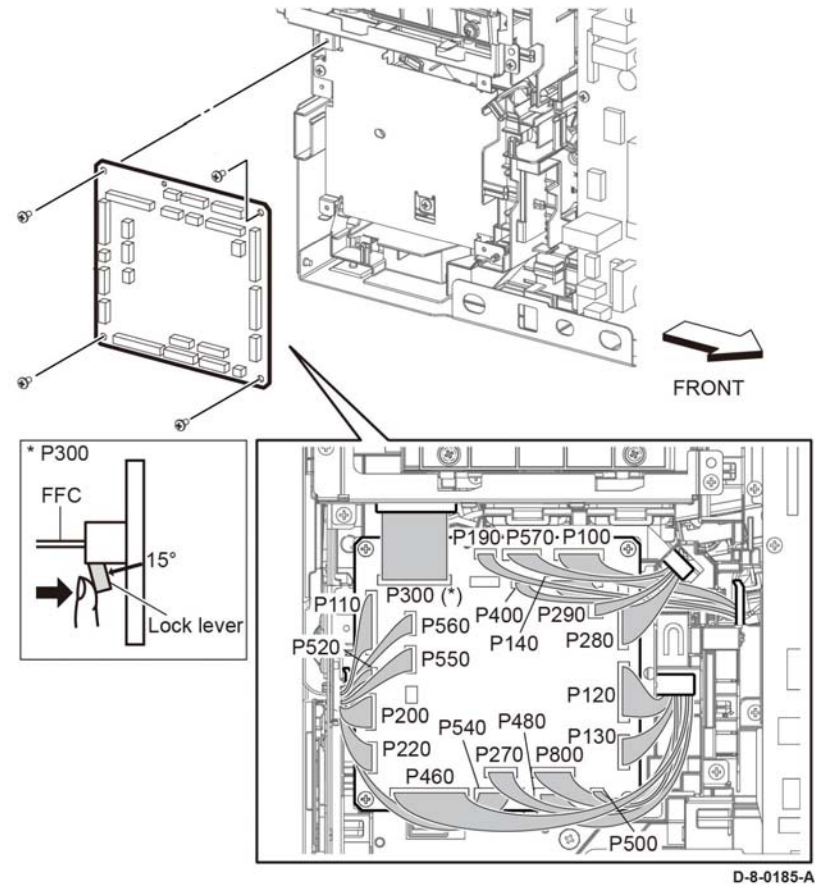
Figure 2 Remove the MCU PWB (SFP)

2. Refer to Figure 2, unplug connectors (P/J100, P/J110, P/J120, P/J130, P/J140, P/J190, P/J200, P/J220, P/J270, P/J280, P/J290, P/J400, P/J460, P/J480, P/J500, P/J520, P/J540, P/J550, P/J560, P/J570, P/J800) and the FFC (P/J300).
3. Refer to Figure 2, remove four screws (silver, M3x6mm) securing MCU PWB, PL 18.9 Item 1, and remove the MCU PWB.

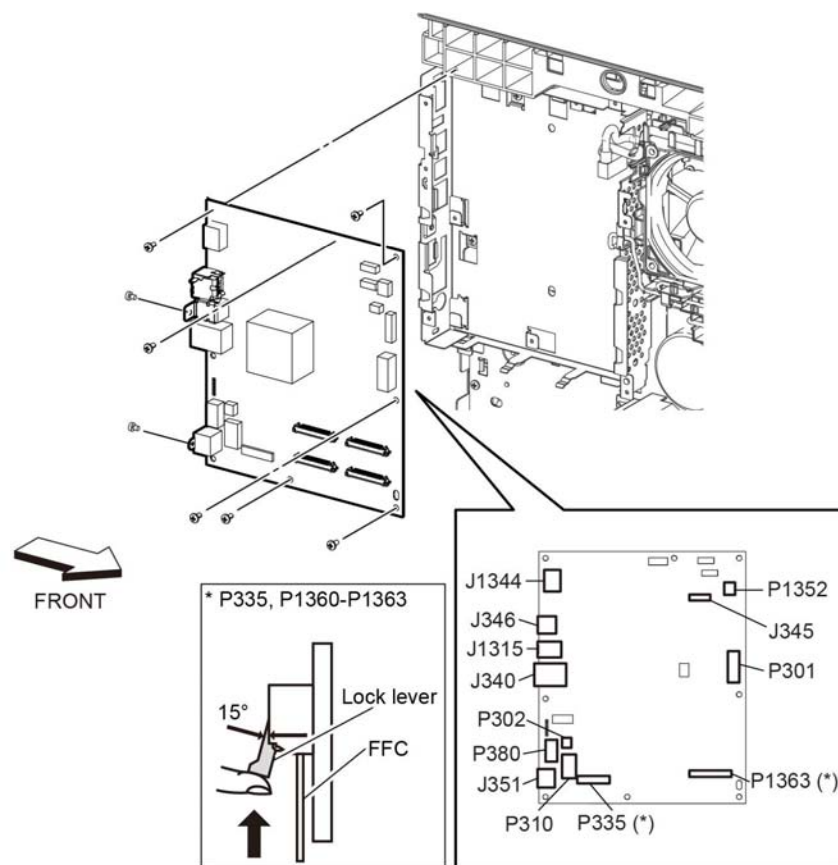
Figure 1 Remove the ESS PWB (SFP)

7. Refer to Figure 1, remove six screws (SM18, silver, M3X6mm) and two screws (SM1, silver, M3Xmm) and Earth plate of the USB connector, and then remove the ESS PWB (SFP), PL 18.9 Item 5.

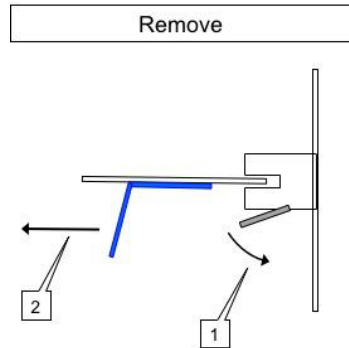
**Figure 2 Proper Removal of the ESS MCU FFC Cable**

*Engage the lever enough to release the FFC only. Over-engagement of the release lever will break the lever destroying the lock mechanism forcing replacement of the PWB.*

*NOTE: When engaging the release lever on the FFC connector, slightly open the release lever no more than 15 degrees. Hold the lever while gently removing the FFC from the connector as shown in Figure 2.*

**NOTE:** Please refer to Figure 1, Proper Removal of the ESS MCU FFC Cable to ensure no damage to the cable or the connector release latch occurs. Damage to the FFC cable and/or release latch could result in replacement required or damage to other components.

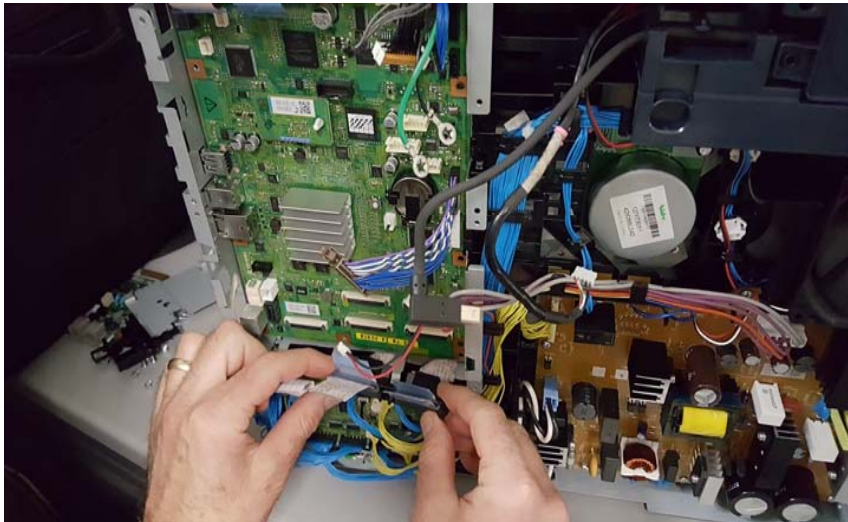
**Figure 3 Disconnect all Cables**

8. Refer to [Figure 3](#), **Disconnect all Cables**, carefully move the harnesses out of the way and remove the ESS PWB from the frame leaving all harnesses and guides in-place.

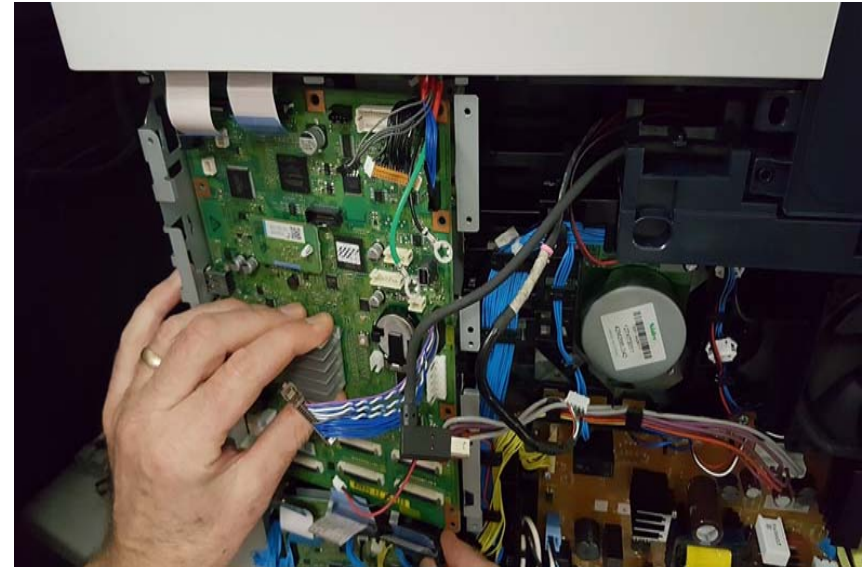
**Figure 4 Lift the Bottom Right Corner from the ESS Frame**

9. Refer to [Figure 4](#), **Lift the Bottom Right Corner from the ESS Frame**, carefully ease the ESS PWB from the ESS Frame.

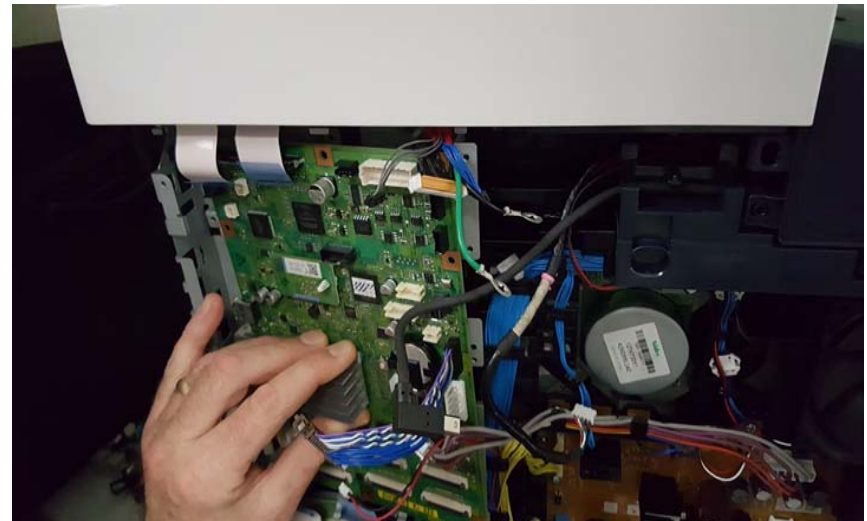
**Figure 5 Slide the ESS PWB from the Right Side of the ESS Frame**

10. Refer to [Figure 5](#), **Slide the ESS PWB from the Right Side of the ESS Frame**, carefully ease the ESS PWB out of the ESS Frame.

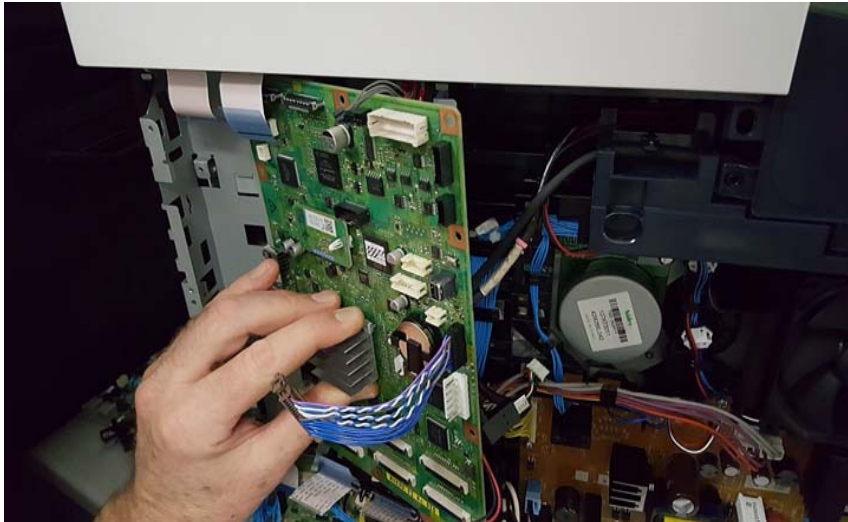
**Figure 6 Remove the ESS PWB from the ESS Frame**

11. Refer to [Figure 6](#), **Slide the ESS PWB Out of the ESS Frame**, to remove the ESS PWB from the ESS Frame entirely.

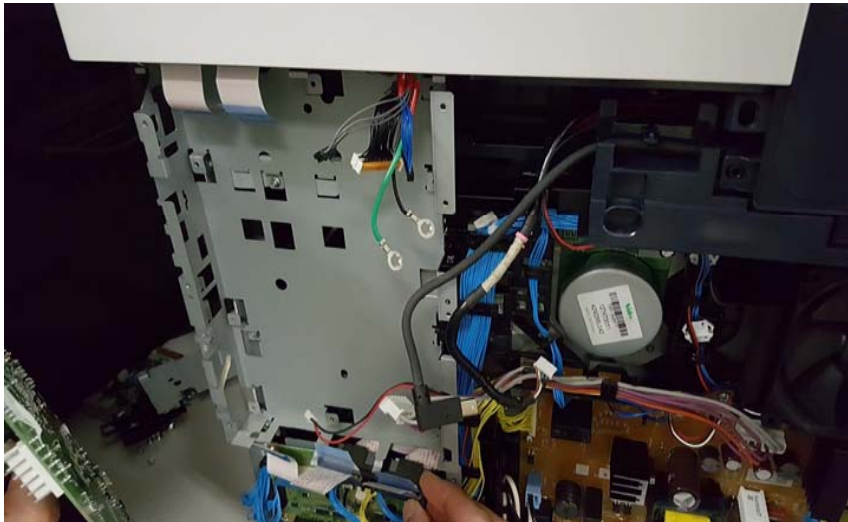
**Figure 7 Removal Complete with FCC Guides Remaining In-place**

12. The ESS PWB removal is complete, [Figure 7](#), **Removal Complete with FCC Guides Remaining In-place**

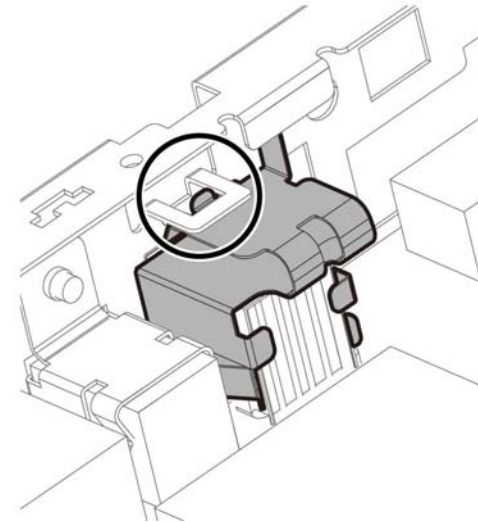
**Figure 8 Earth plate of the USB Connector in the ESS Box.**

When installing the ESS PWB (SFP), check that the Earth plate of the USB connector catches in the ESS Box (SFP), PL18.9/19 as shown in the [Figure 8](#), **Earth plate of the USB Connector in the ESS Box** below.

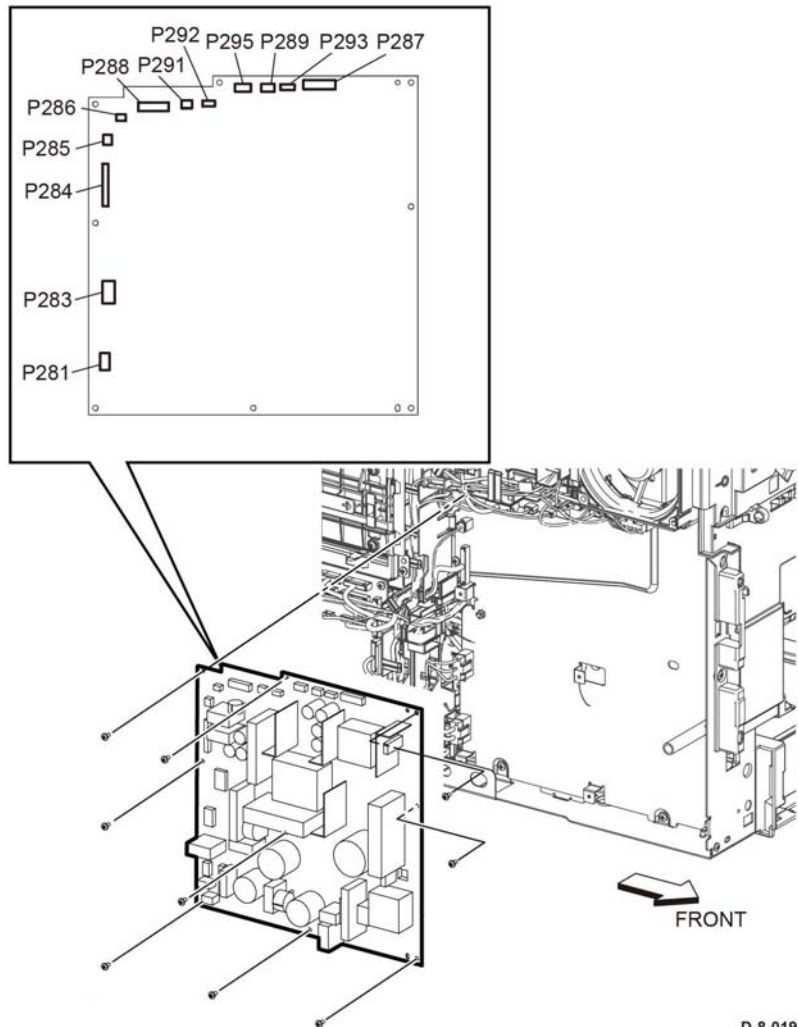
Figure 1 Remove the LVPS PWB (SFP High Model C600)

1. Remove the left side cover, [PL 19.3 Item 4](#).
2. Refer to [Figure 1](#), unplug the connectors (P/J281, P/J283, P/J284, P/J285, P/J286, P/J287, P/J288, P/J289, P/J291, P/J292, P/J293, P/J295) from the LVPS PWB.
3. Refer to [Figure 1](#), remove nine screws (silver, M3x6mm) attaching the LVPS PWB to the LVPS plate, and remove the LVPS PWB.

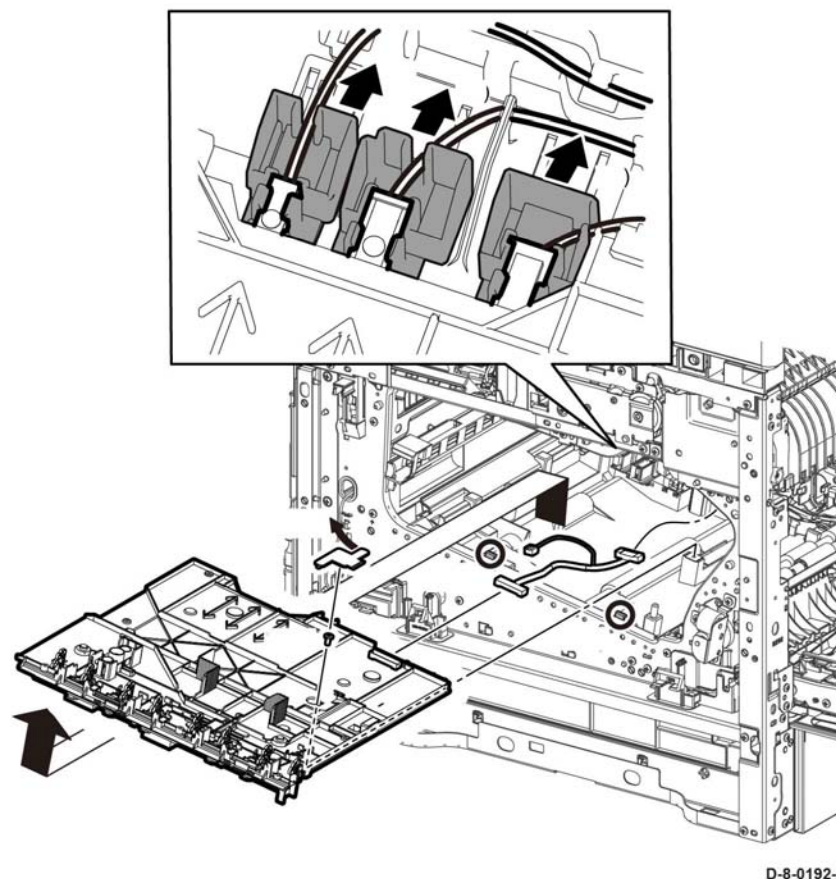
Figure 1 Remove the HVPS guide assembly (SFP)

1. Remove the LPH xerographic CRUM FFC, [PL 8.1](#).
2. Refer to [Figure 1](#), remove the HVPS toner cover, [PL 18.9 Item 3](#), and remove one screw, (SM18, silver, M3x6mm).
3. Refer to [Figure 1](#), push the faston plug holders in the direction of the arrows to disconnect the faston plugs from their terminals (P/J501, P/J502, T601).
4. Refer to [Figure 1](#), unplug the connector (P/J100) from the HVPS guide assembly.
5. Refer to [Figure 1](#), release the two hooks and remove the HVPS guide assembly in the direction of the arrow.

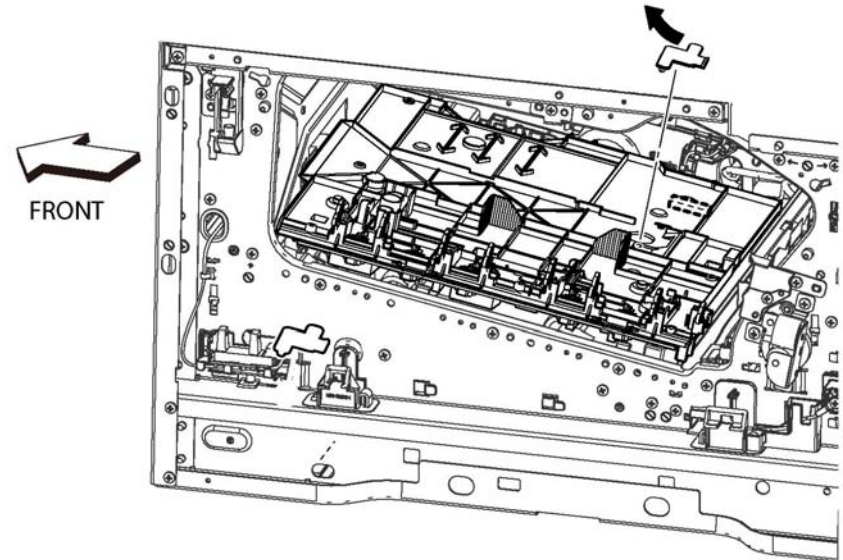
Figure 1 Remove the HVPS toner cover (SFP)

1. Remove the drum cartridges Y, M, C, K, [PL 8.1](#).
2. Refer to [Figure 1](#), remove the HVPS toner cover, [PL 18.10 Item 3](#).

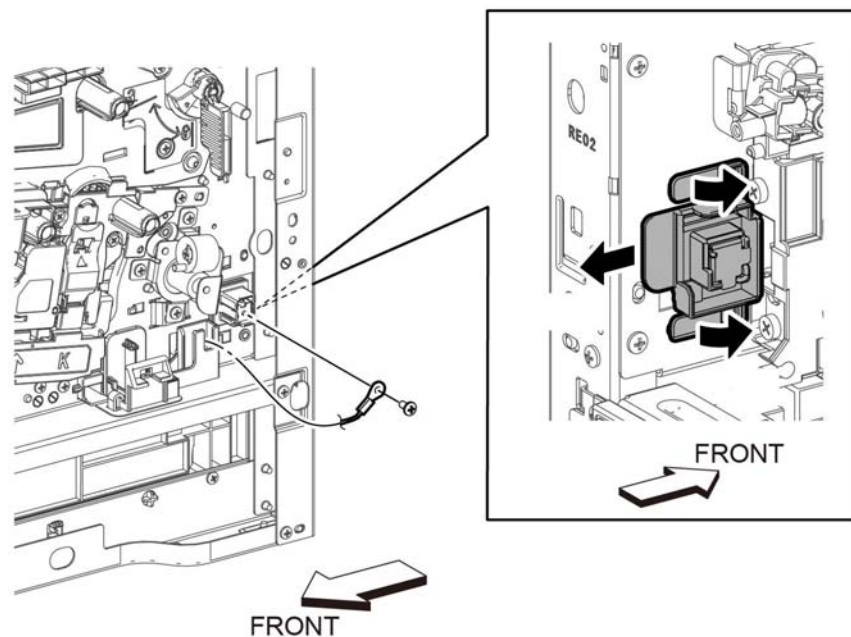
Figure 1 Remove the second bias transfer housing kit (SFP)

1. Open the Rear Door, [PL 19.2 Item 99](#).
2. Refer to [Figure 1](#), remove the one screw (silver, M3x6mm) attaching the high voltage harness.
3. Refer to [Figure 1](#), release two hooks on the second bias transfer housing and remove the housing.

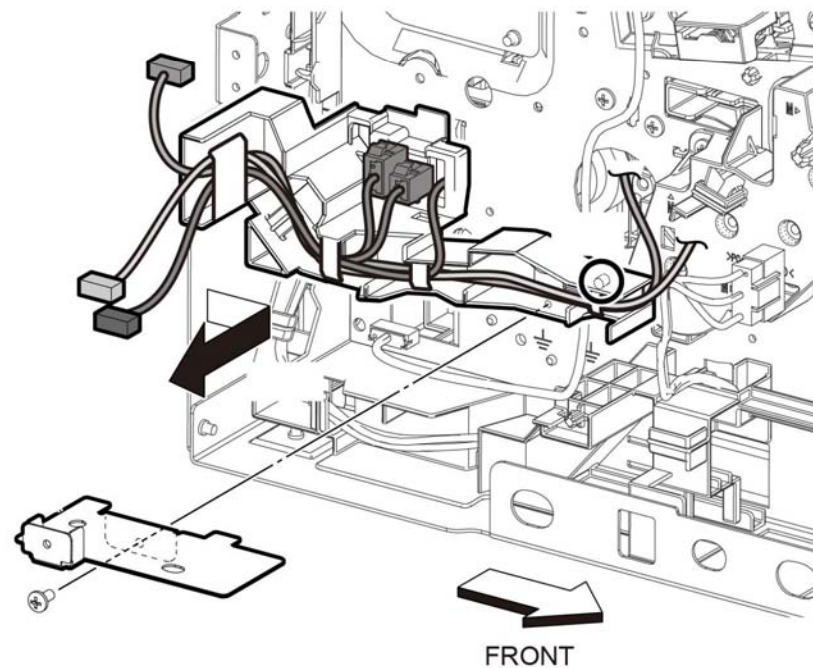
Figure 1 Remove one screw to remove the plate (SFP)

1. Remove the exit chute assembly, [PL 17.1 Item 1](#) (C600) (C500).
2. Release one boss of the harness guide, and slightly release the harness guide with the harnesses in the direction of the arrow.
3. Refer to [Figure 1](#), remove one screw (SM18, silver, M3X6mm) to remove the plate.

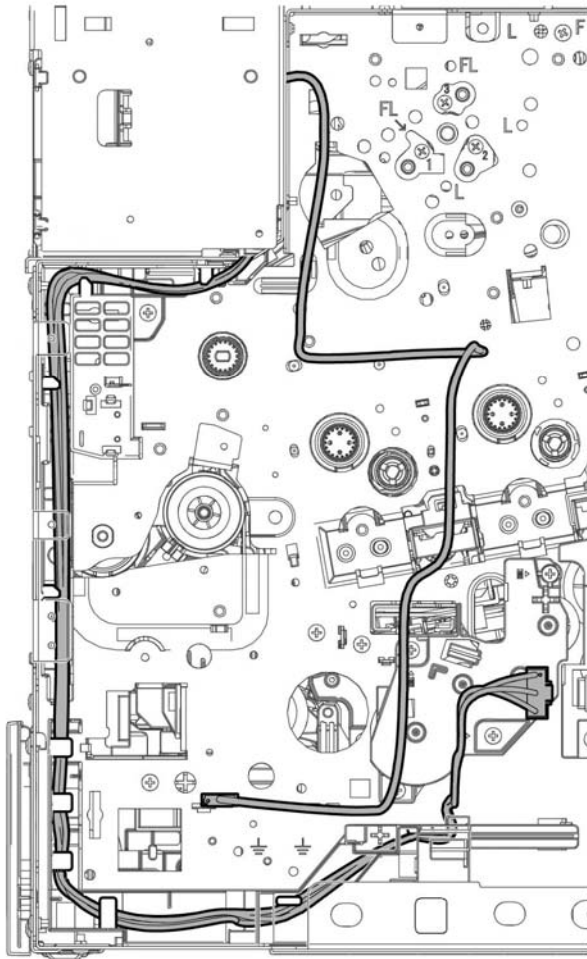
**Figure 2 Release the AC fusing harness assembly from the harness guides (SFP)**

5. Release the AC fusing harness assembly, [PL 18.11 Item 3](#), from the harness guides.

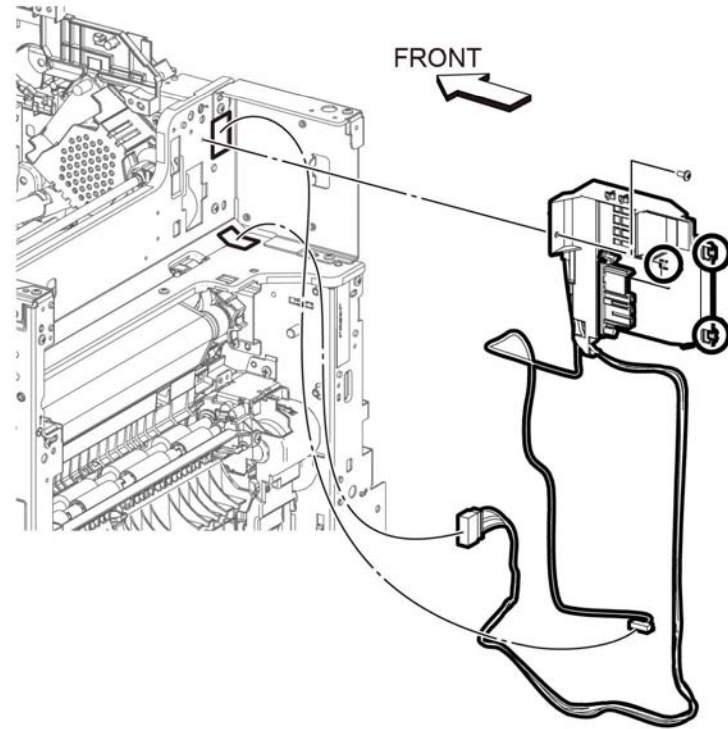
**Figure 3 Remove the DC-CF fusing harness assembly (SFP)**

6. Remove one screw (SM18, silver, M3X6mm), and release three hooks to remove the DC-CF fusing harness assembly, [PL 18.11 Item 2](#), and AC fusing harness assembly with the fusing harness guide.
