# VersaLink® B600/B610 Printer and B605/B615 Multifunction Printer Service Manual

Xerox® VersaLink® B600 Family MFP Service Manual

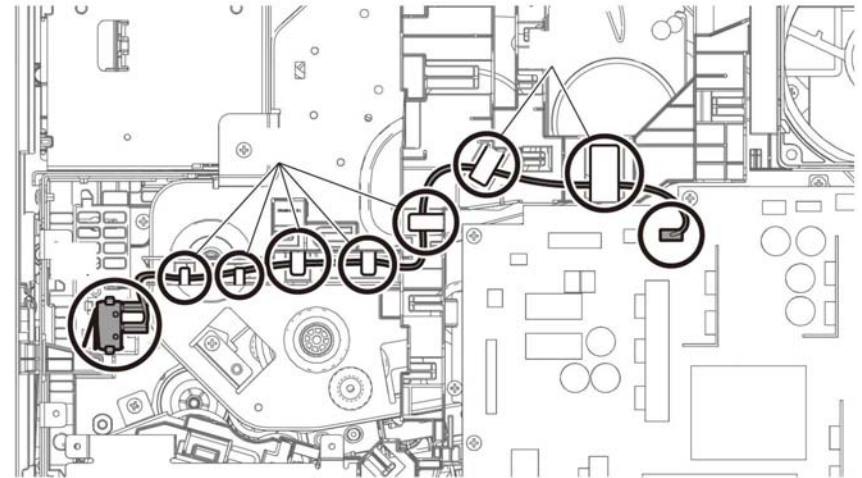
Figure 1 Remove the Rear-CF Interlock harness assembly (SFP)

1. Remove the ESS PWB, [PL 18.3 Item 3](#).
2. Remove the ESS Box, [PL 18.3 Item 15](#).
3. Refer to [Figure 1](#), unplug the connector (P/J292) from the LVPS PWB and release the cable from the cable guide.
4. Refer to [Figure 1](#), release the two hooks and remove the Rear-CF interlock harness assembly.

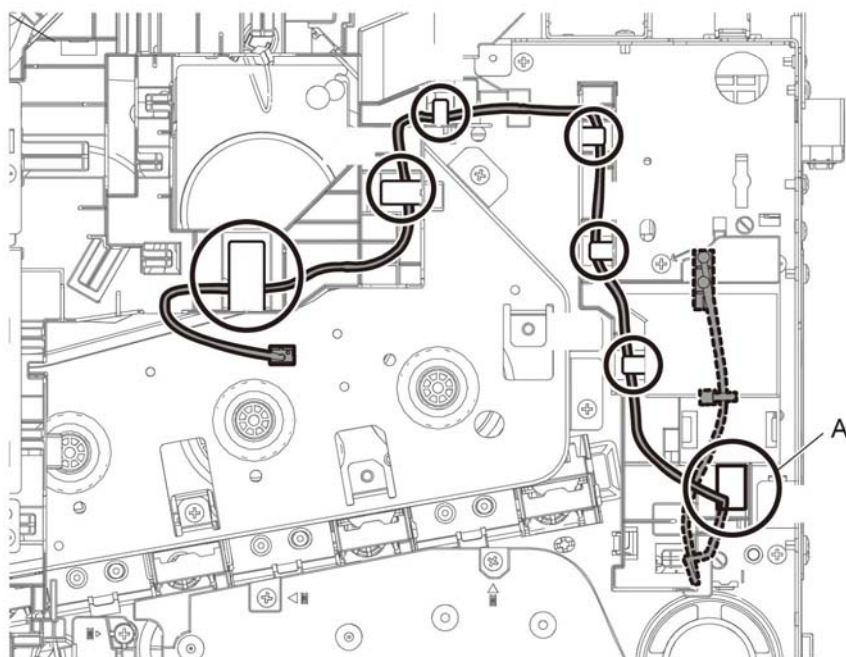
Figure 1 Side interlock harness release

1. Remove the LVPS PWB, [PL 18.3 Item 6](#).
2. Remove the LVPS plate, [PL 18.3 Item 13](#).
3. Refer to [Figure 1](#), release the harness of the Side-CF IL harness assembly from the three hooks.
4. Pull out the Side-CF I/L harness assembly from hole A.

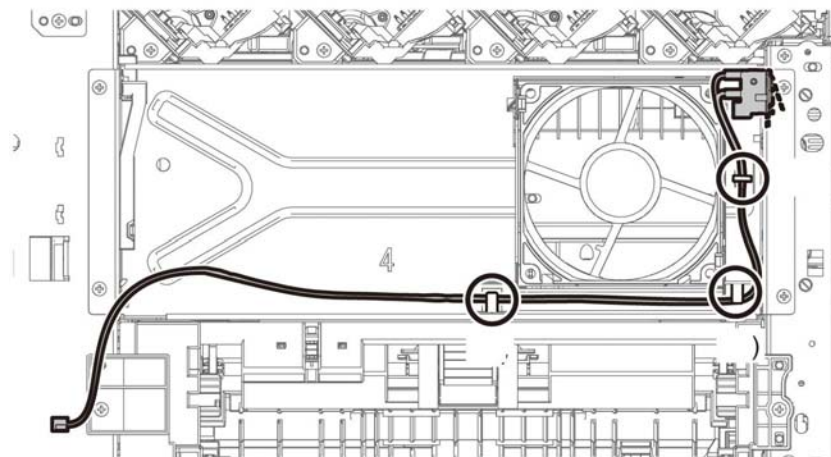
Figure 2 Side-CF I/L harness assembly release (SFP)

5. Refer to [Figure 2](#), release the Side-CF I/L harness assembly from the sub fan duct, [PL 4.1 Item 4](#).

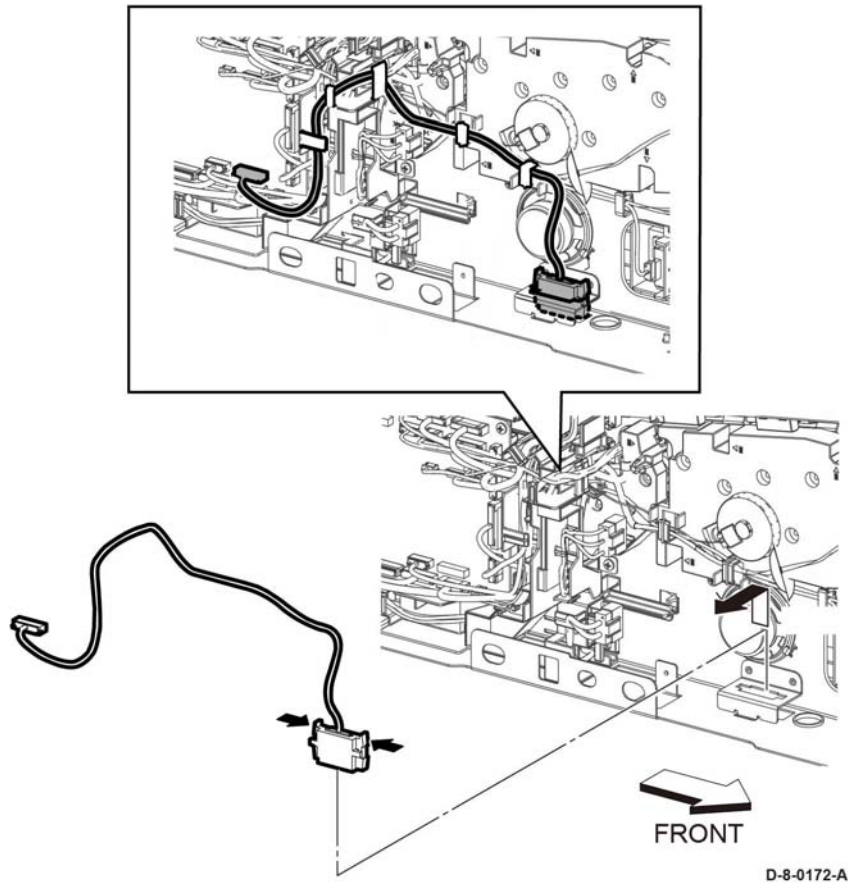
2. Refer to [Figure 1](#), unplug the connector, P/J191.
3. Refer to [Figure 1](#), remove one screw, (ST20, silver, metal) and remove the size switch assembly.

Figure 1 Remove the OPF harness assembly (SFP)

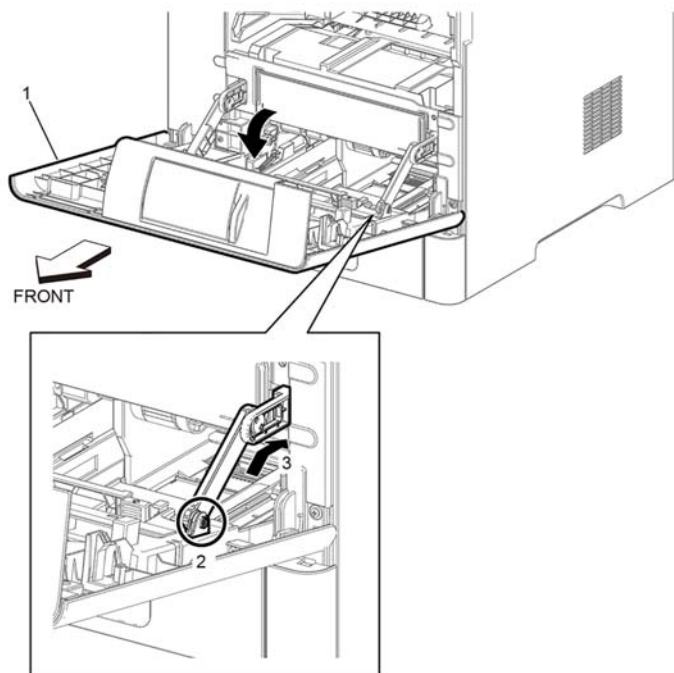
D-8-0229-A

1. Remove the IOT 550 Feed Tray Assembly, [REP 9.1](#).
2. Remove the finisher or mailbox if installed.
3. Release the front cover assembly, [Figure 1](#):
  - a. Open front cover assembly (1).
  - b. Release the boss of each link (L/R) from the front cover assembly (2).
  - c. Slide the links (L/R) into the printer (3).

Figure 1 Front cover assembly release

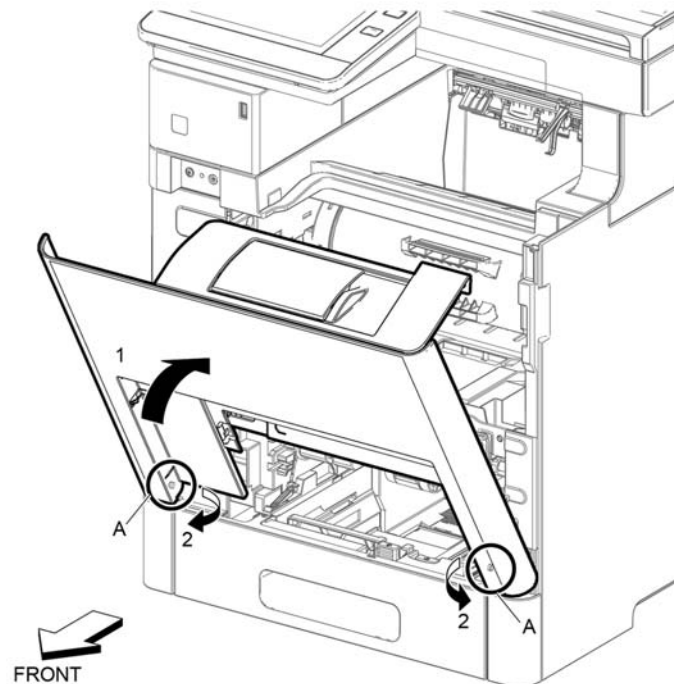
B-1-0229-B

4. Remove the front cover assembly, [Figure 2](#):
  - a. Close the cover assy front to the position shown (1).
  - b. Remove the front cover assembly (2) while flexing the part (A) to release the bosses.

Figure 2 Front cover assembly removal

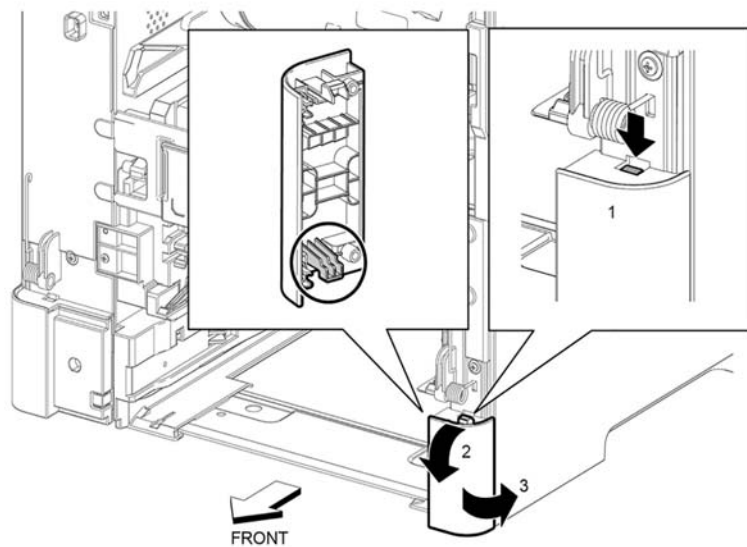
B-8-0232-B

1. Remove the right side front cover, [Figure 1](#):
  - a. Press the hook release button (1).
  - b. Rotate the top of the right front cover in the direction of the arrow (2).
  - c. Remove the right front cover in the direction of the arrow (3).

Figure 1 Right side front cover removal

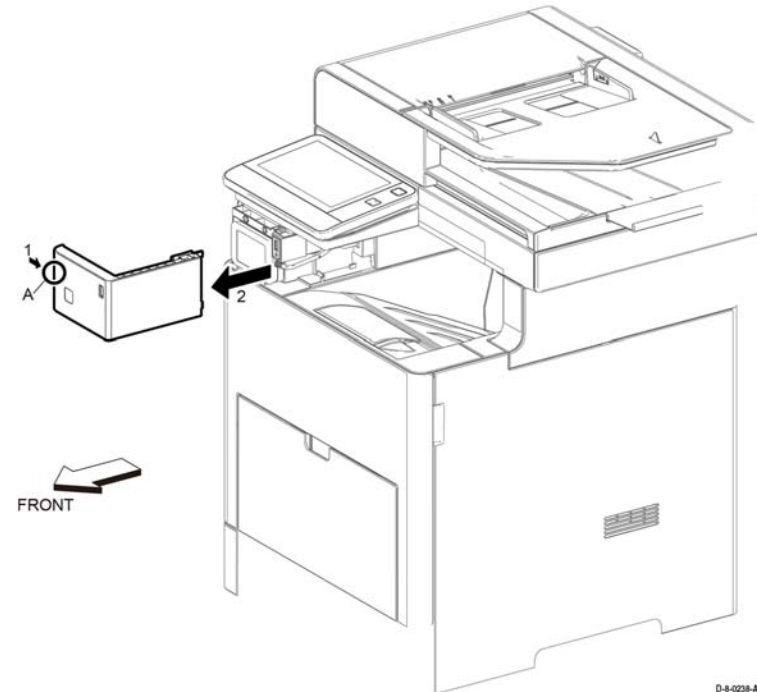
D-8-0238-A

Figure 1 ICCR cover removal

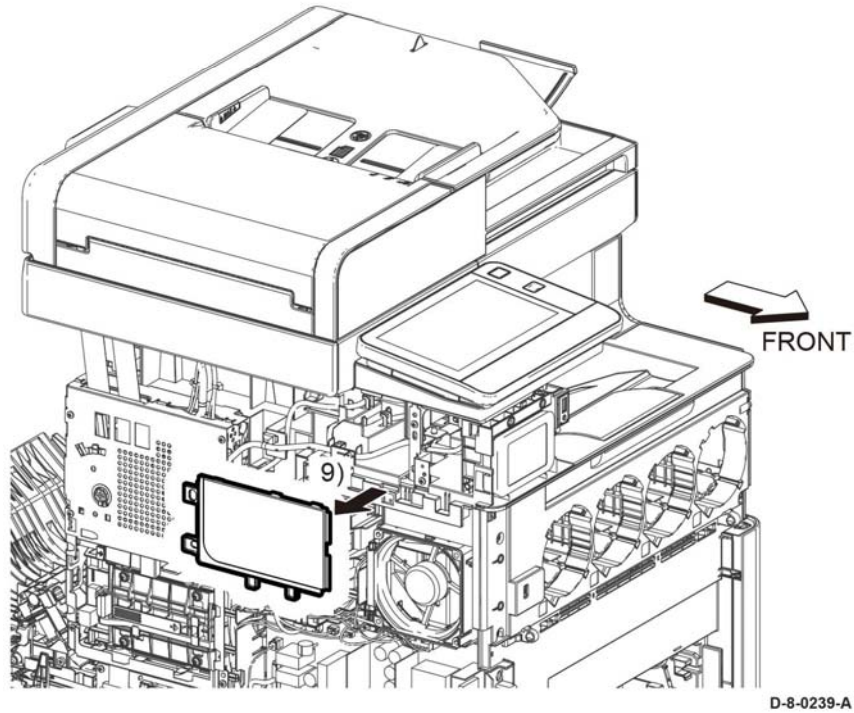
- Refer to [Figure 2](#), remove the left side IIT cover in the direction of the arrow

Figure 2 Remove the Left Side IIT Cover (MFP)

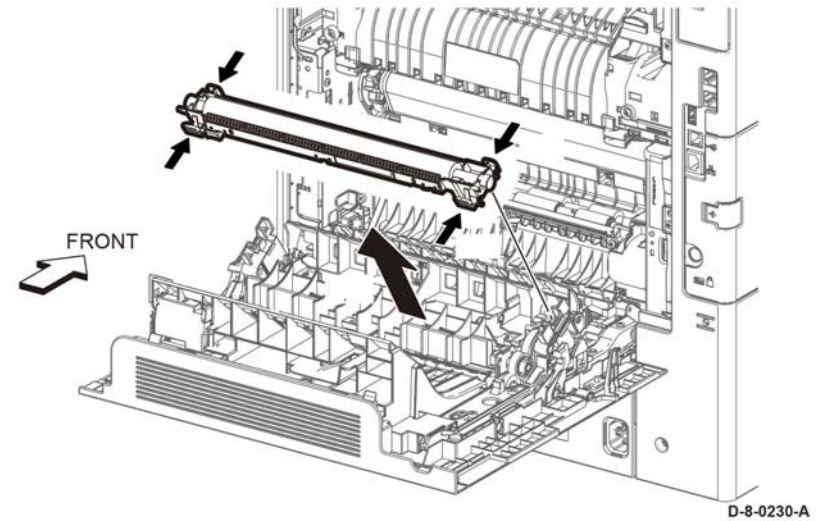
- Open the rear door, [PL 19.1 Item 99](#).
- Squeeze the four latches and remove the 2nd BTR roll assembly.

Figure 1 Remove the Second Bias Transfer Roller Assembly (MFP)

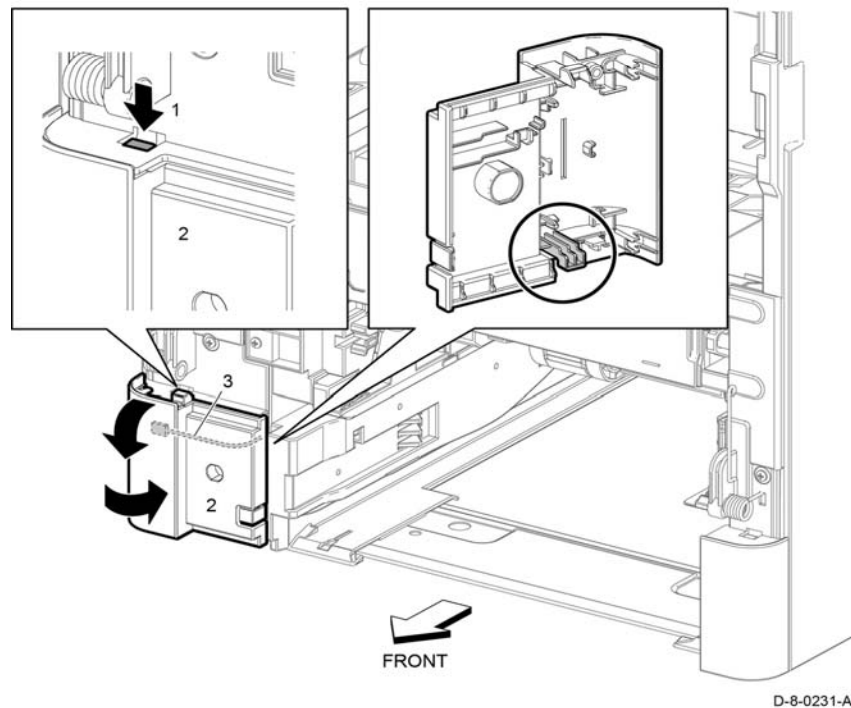
1. Remove the left front cover, [Figure 1](#):
  - a. Push the release button in the direction of the arrow (1) to release the front left cover (2).
  - b. Disconnect (P/J512) (3), then remove the left front cover (2) with the tray led PWB, [PL 19.1 Item 24](#) and the tray shade cover, [PL 19.1 Item 25](#).

Figure 1 Remove the left front cover

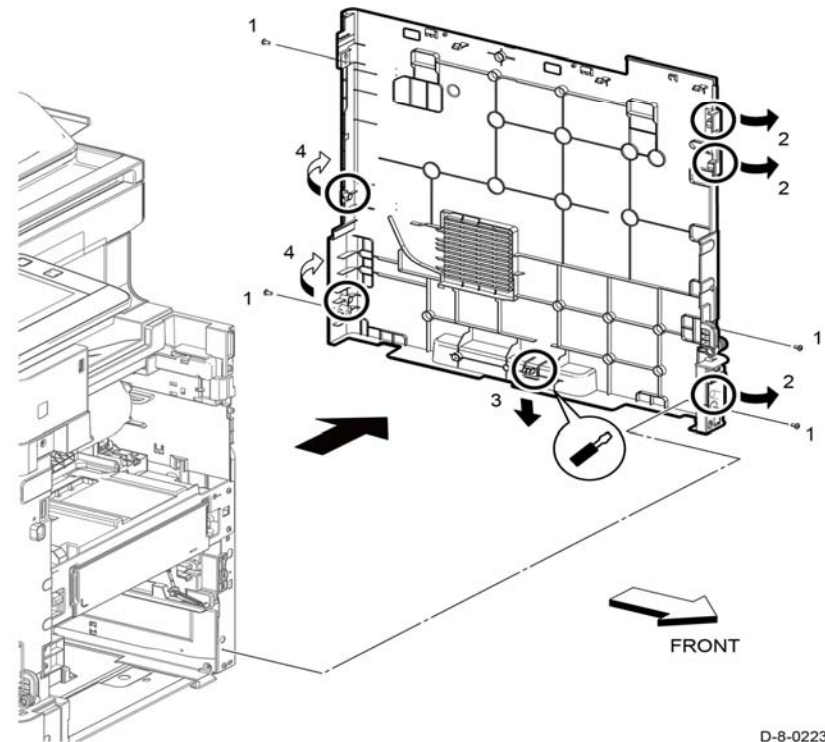
1. 550 IOT cassette assembly, [REP 9.1](#).
2. Main MSI tray assembly, [REP 13.6](#).
3. Right front cover, [REP 19.2](#).
4. Open the rear door, [PL 19.2 Item 99](#).
5. Remove the right side cover assembly, [Figure 1](#):
  - a. Remove four screws (1).
  - b. Release the bosses (2) on the front of the cover.
  - c. Release one hook (3) on the bottom of the cover.
  - d. Release two bosses (4) on the rear of the cover, then remove the cover.

Figure 1 Right side cover removal

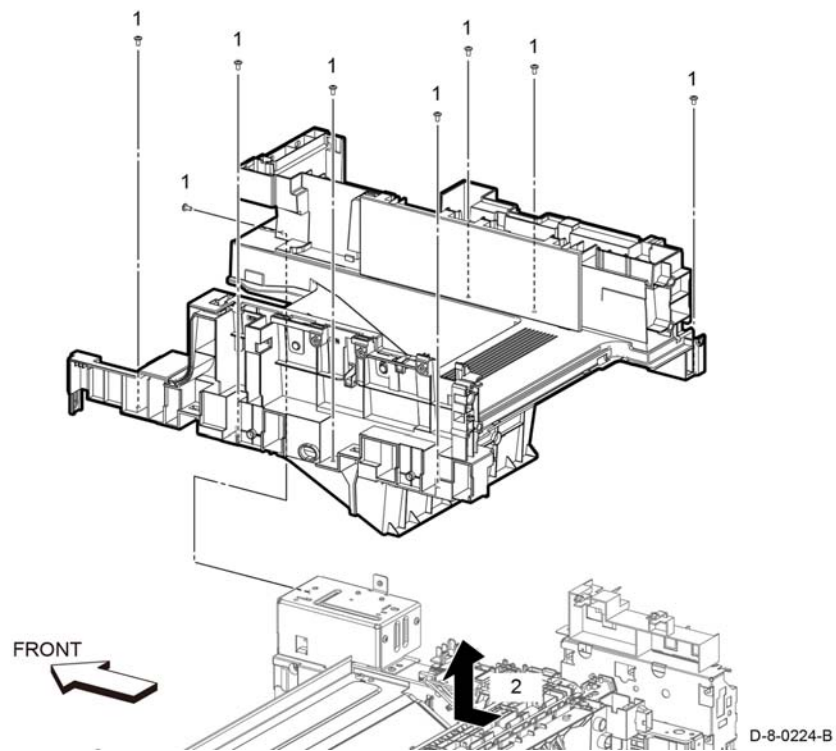
1. Remove the DADF assembly, [REP 50.1](#).
2. Open the rear door, [PL 19.2 Item 99](#).
3. Remove the top cover, [Figure 1](#):
  - a. Remove eight screws (1).
  - b. Lift up and remove the top cover assembly (2).

**NOTE:** This includes the right IIT inner cover and left IIT inner cover.

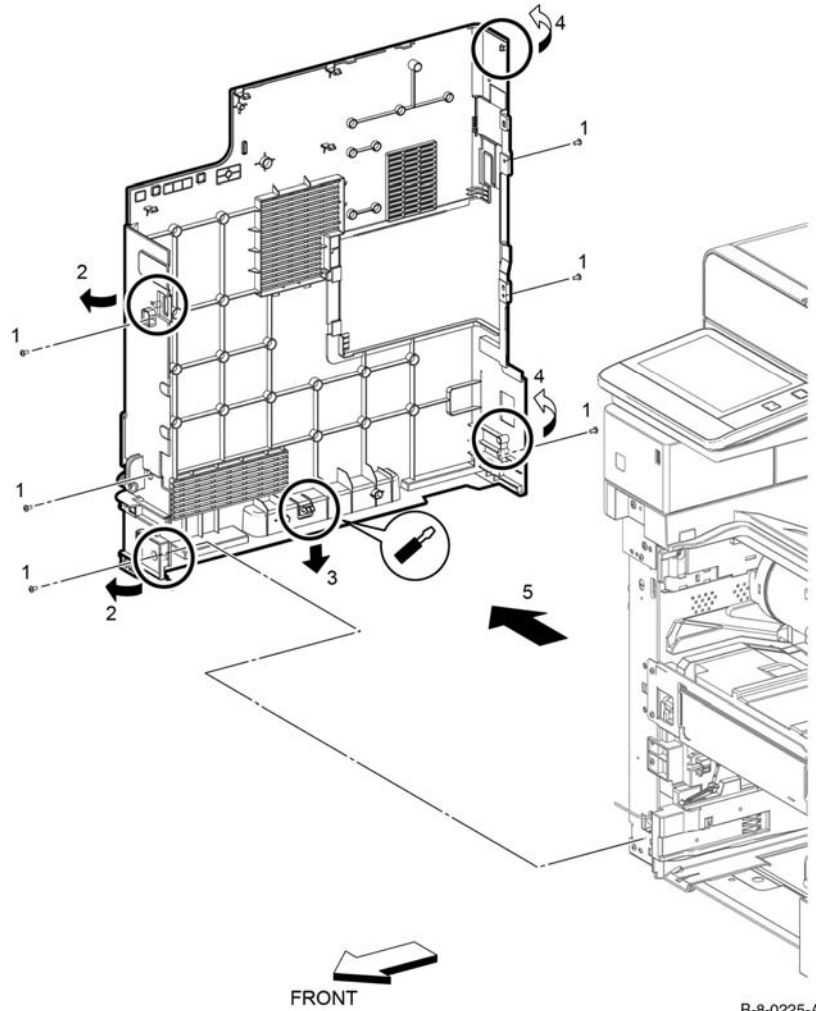
Figure 1 Left side cover removal

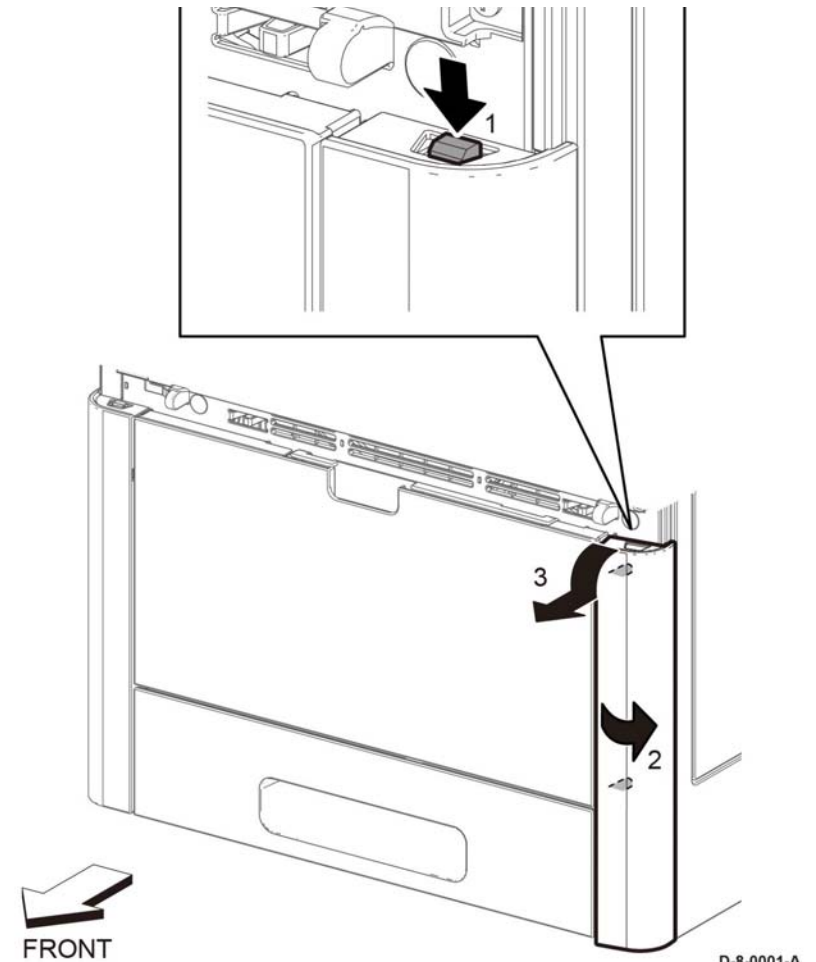
D-8-0001-A

1. Remove the toner cover, [PL 19.1 Item 1](#).
2. Remove the MSI tray, [PL 13.2 Item 1](#).
3. Remove the IOT 550 cassette, [PL 9.1 Item 1](#).
4. Refer to [Figure 1](#), push and release button to release the hook at the top end of the right side front cover.
5. Press in at the two bosses and remove the right side front cover in the direction of the arrow.

Figure 1 Remove the Right Side Front cover (SFP)

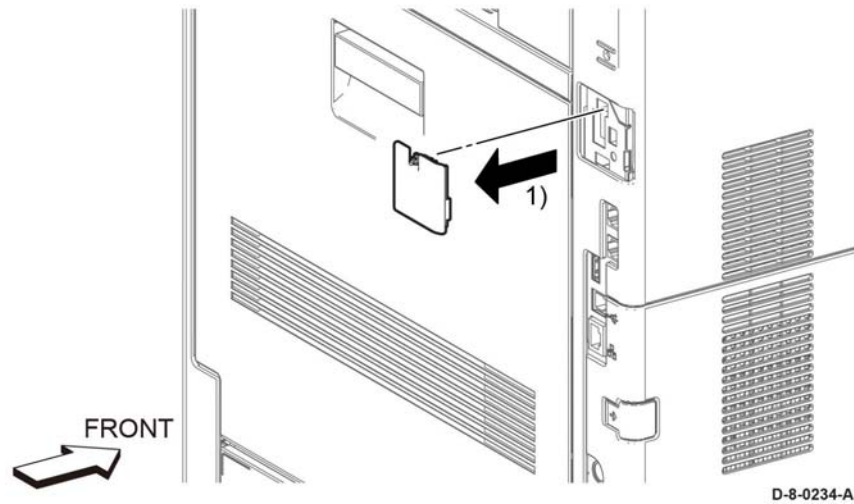
1. Release the hook, then remove the WIFI cap, [Figure 1](#).

Figure 1 Remove the WIFI cap (MFP)

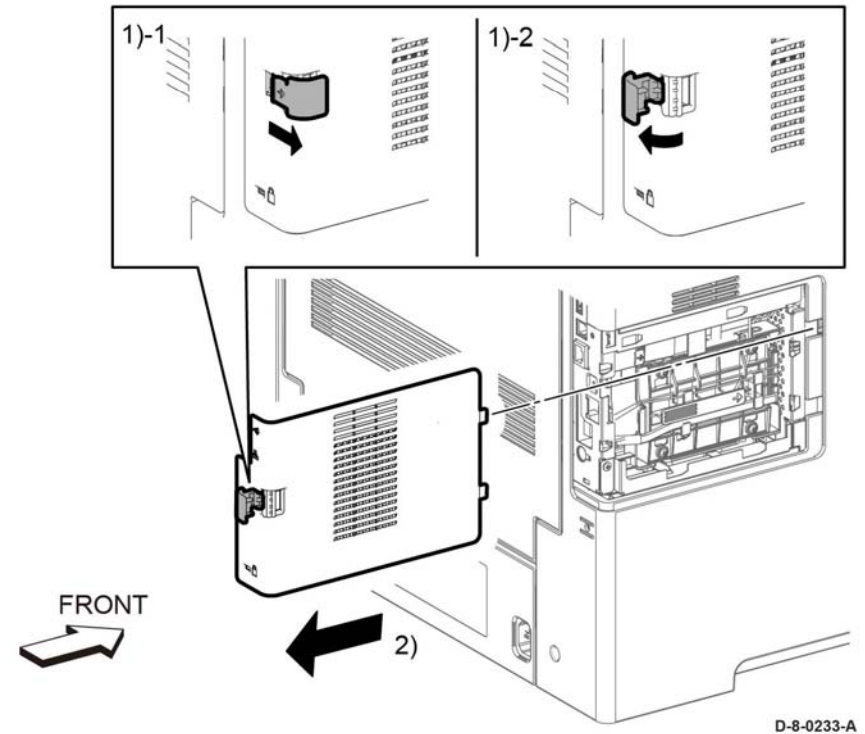
1. Perform the items that follow [Figure 1](#):
  - 1-1 Slide the lever as shown.
  - 1-2 rotate the lever as shown.
2. Remove the ESS window assembly.

Figure 1 Remove the ESS window assembly (MFP)

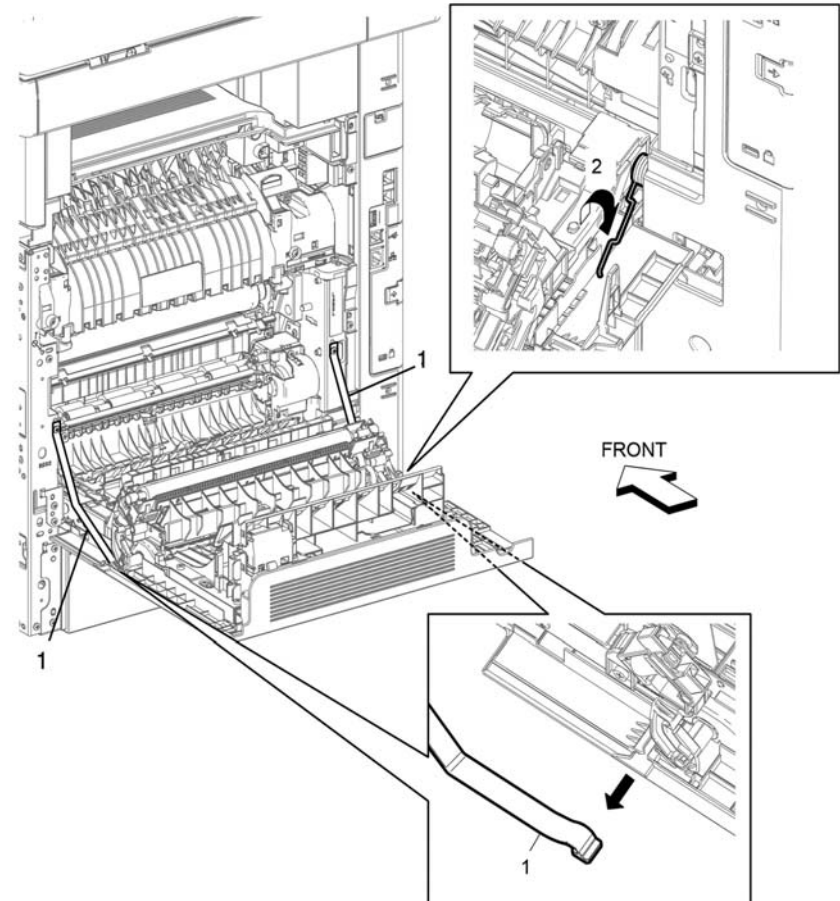
D-8-0227-A

3. Release two straps (1) and one spring (2), [Figure 1](#):

Figure 1 Remove the rear cover assembly (MFP)

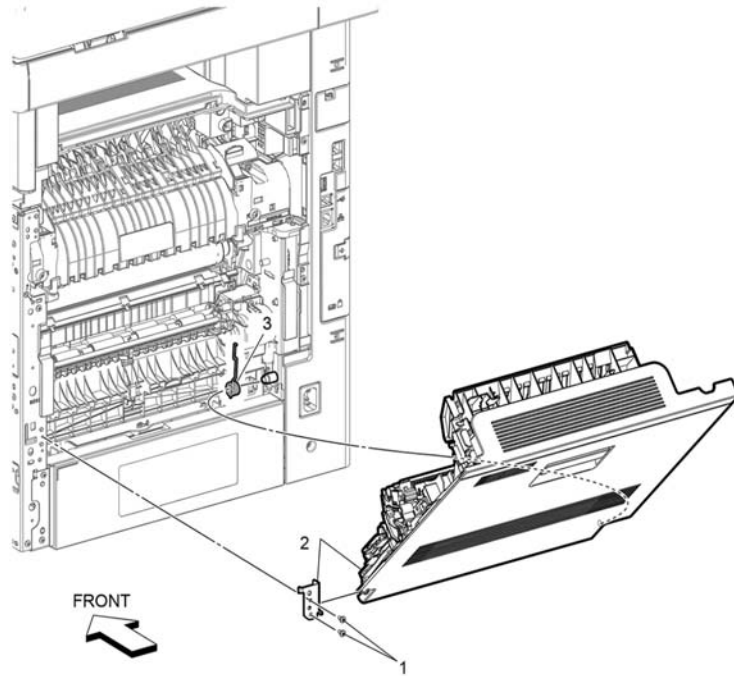
5. Remove the rear cover assembly, [Figure 2](#).
  - a. Remove two screws (1) connecting the right rear hinge assembly (2).
  - b. Remove the right rear hinge assembly (2) and the rear cover assembly while opening the rear cover assembly.
  - c. Remove the rear cover spring (3).

Figure 2 Remove the rear cover assembly

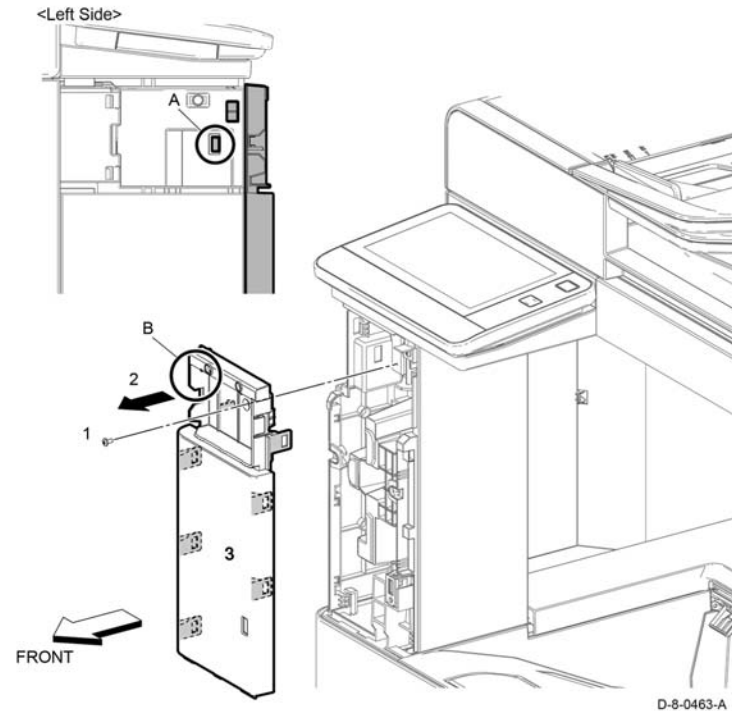
1. Remove the ICCR FIN Cover, [PL 19.3 Item 40](#).
2. Remove the front inner cover, [Figure 1](#):
  - a. Remove one screw (1).
  - b. Release tab (A), then pull at location (B) to remove the front inner cover (3).

Figure 1 Remove the front inner cover

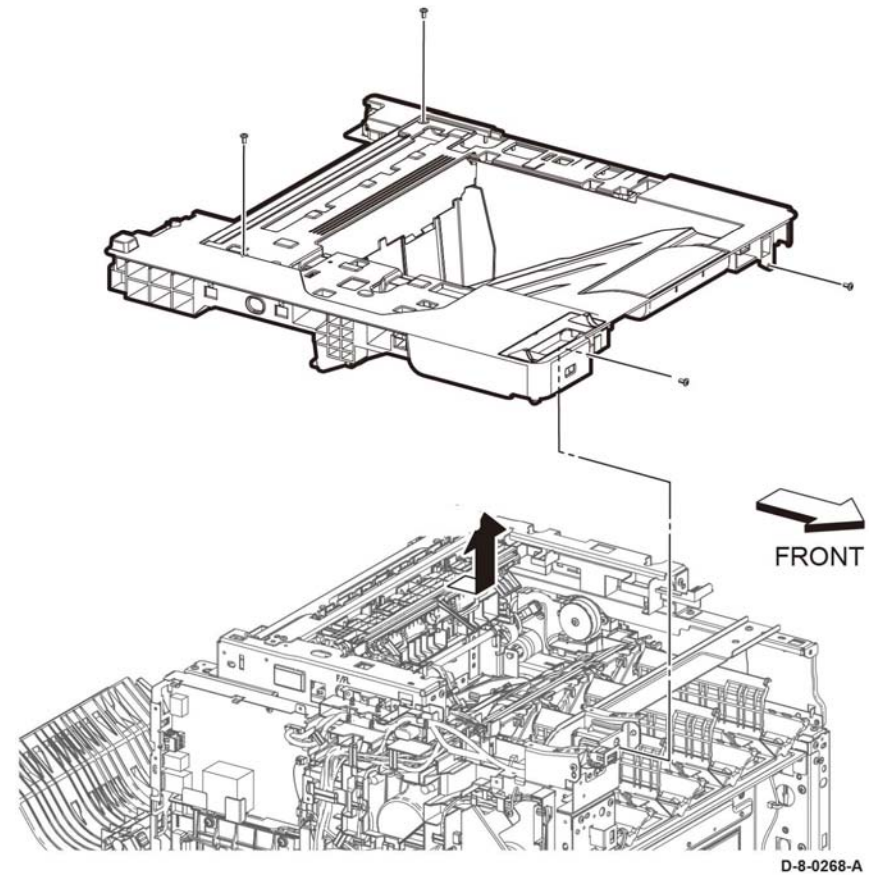
1. Remove the 250 Sheet Cassette. [PL 9.1](#)
2. Remove the Main Bypass Tray Assembly. [PL 13.1](#)
3. Remove the Right Side Cover. [PL 19.5 Item 8](#)
4. Remove the Left Side Cover. [PL 19.6 Item 1](#)
5. Remove the Front Inner Cover. [PL 19.5 Item 96](#)
6. Remove the Left Rear Top Cover. [PL 19.5 Item 9](#)
7. Remove the Right Rear Top Cover. [PL 19.5 Item 10](#)
8. Open the Rear Cover.
9. Remove the UI Console. [PL 1.2](#)
10. Remove the three screws (silver, M3x6mm) attaching the Top Cover Assembly, then lift up the cover. [Figure 1](#).

Figure 1 Remove the Top Cover Assembly (SFP)

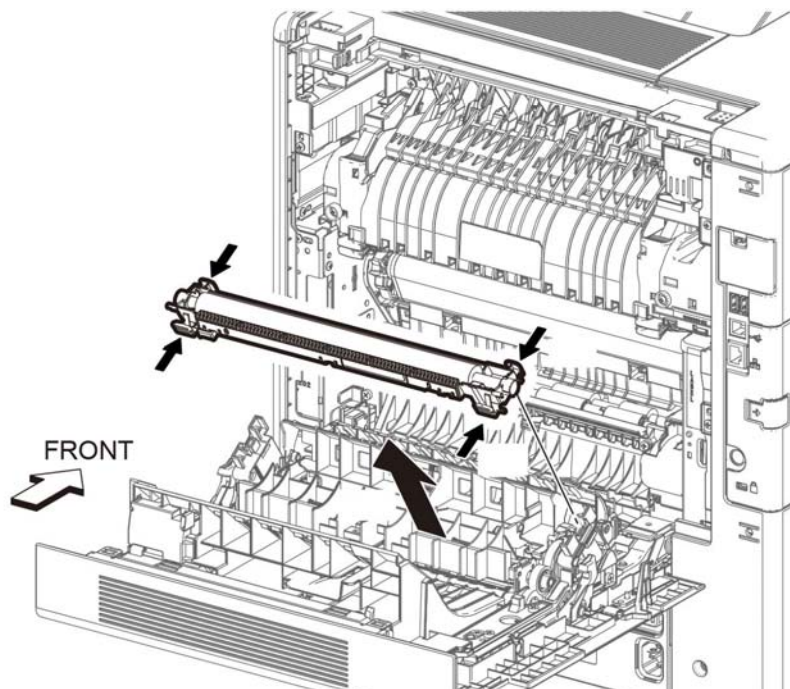
1. Open the Rear Cover.
2. Refer to [Figure 1](#), to release the four latches attaching the Second Bias Transfer Roller and remove the roller assembly.

Figure 1 Remove the Second Bias Transfer Roller Assembly (SFP)

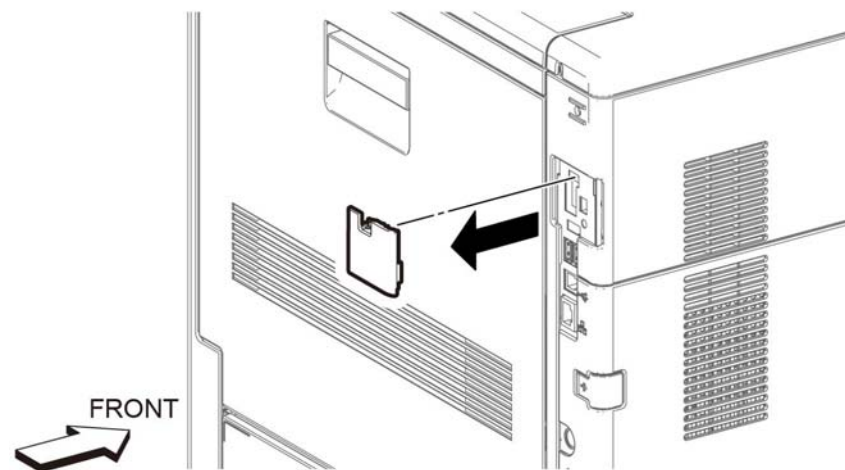
D-8-0278-A

1. Refer to [Figure 1](#), to release the lever in the direction of the arrow.

Figure 1 Remove the ESS Window Assembly (SFP)

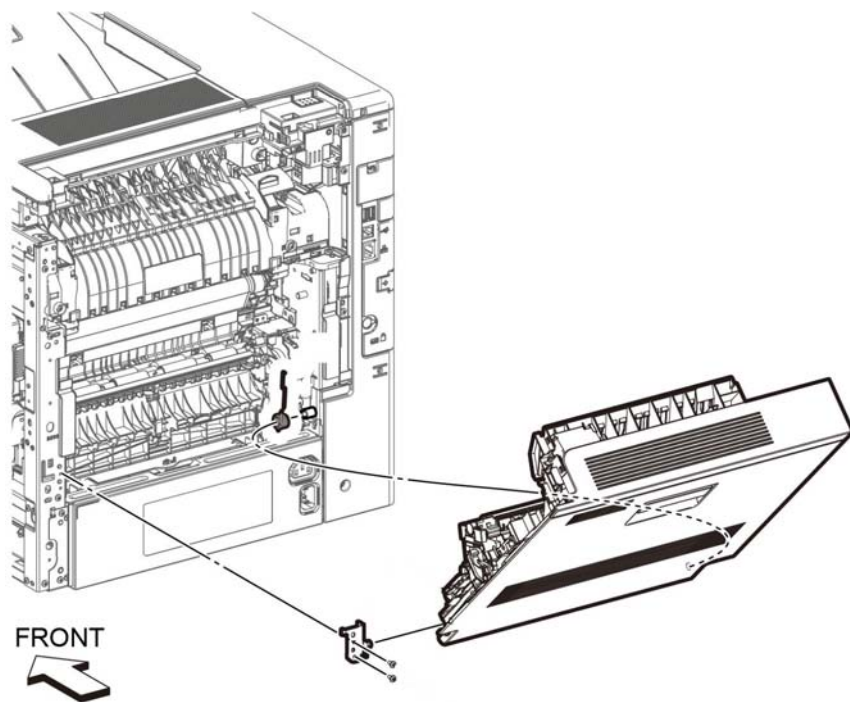
D-8-0272-A

1. Remove the right side cover.
2. Open the Rear Cover.
3. Refer to [Figure 1](#), to remove the ends of the two rear cover straps from the rear cover.
4. close the rear cover.
5. Refer to [Figure 1](#), to remove the two screws (silver, M3x6mm) attaching the right rear hinge.

Figure 1 Remove the Rear Cover Assembly (SFP)

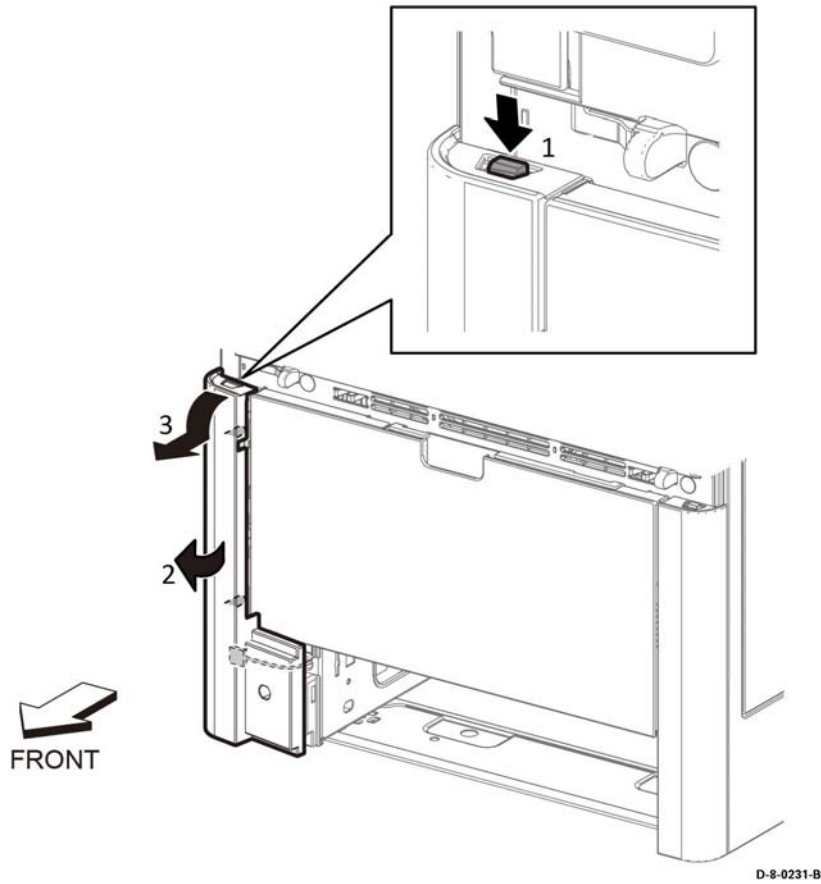
- 1-3 Remove the left front cover.
2. Refer Disconnect the connector, P/J521.

**Figure 1 Remove the left side front cover**

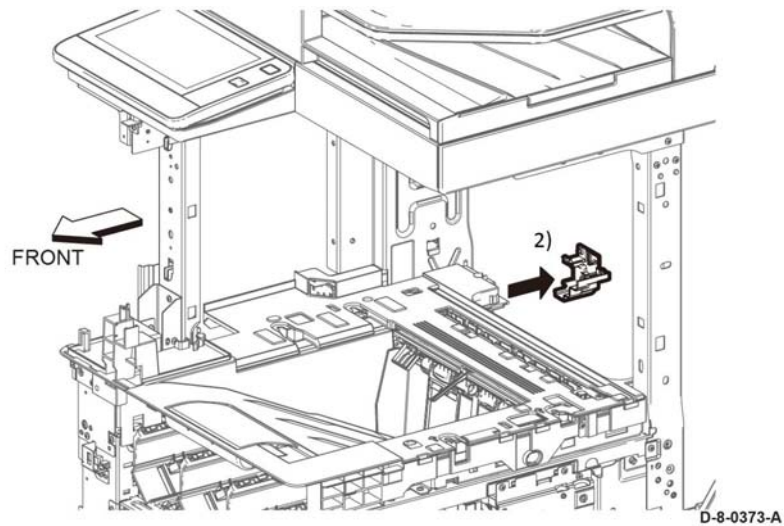
1. Open the rear cover assembly, [PL 19.2 Item 99](#).
2. Remove the OPT blind cover, [Figure 1](#):

Figure 1 Remove the OPT blind cover

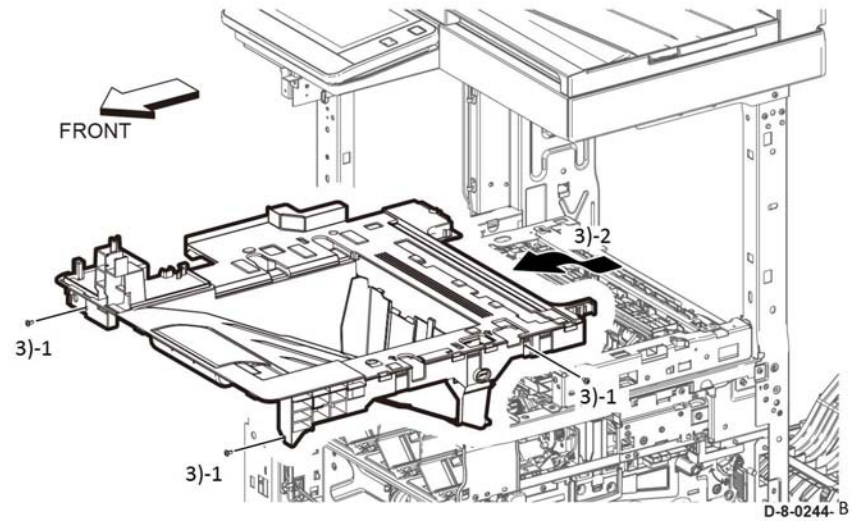
3. Perform the items that follow:
  - 3-1 Remove three screws SM18.
  - 3-2 Remove the top cover assembly.

Figure 2 Remove top cover

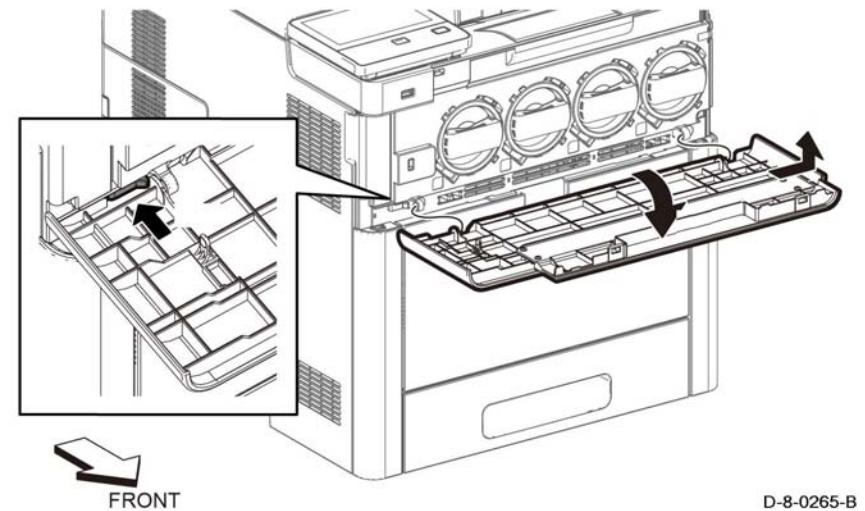
Figure 1 Toner cover assembly removal

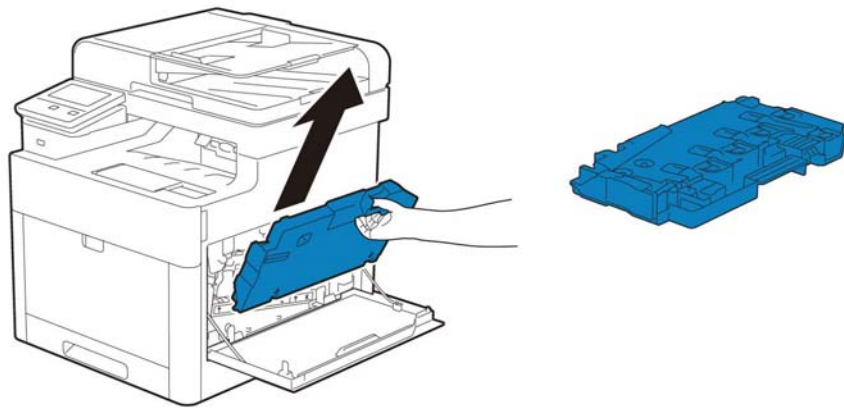
D-8-0462-A

1. Open the waste box cover on the right side, press the tab and remove the waste toner assembly, Figure 1.

Figure 1 Remove the toner waste box assembly

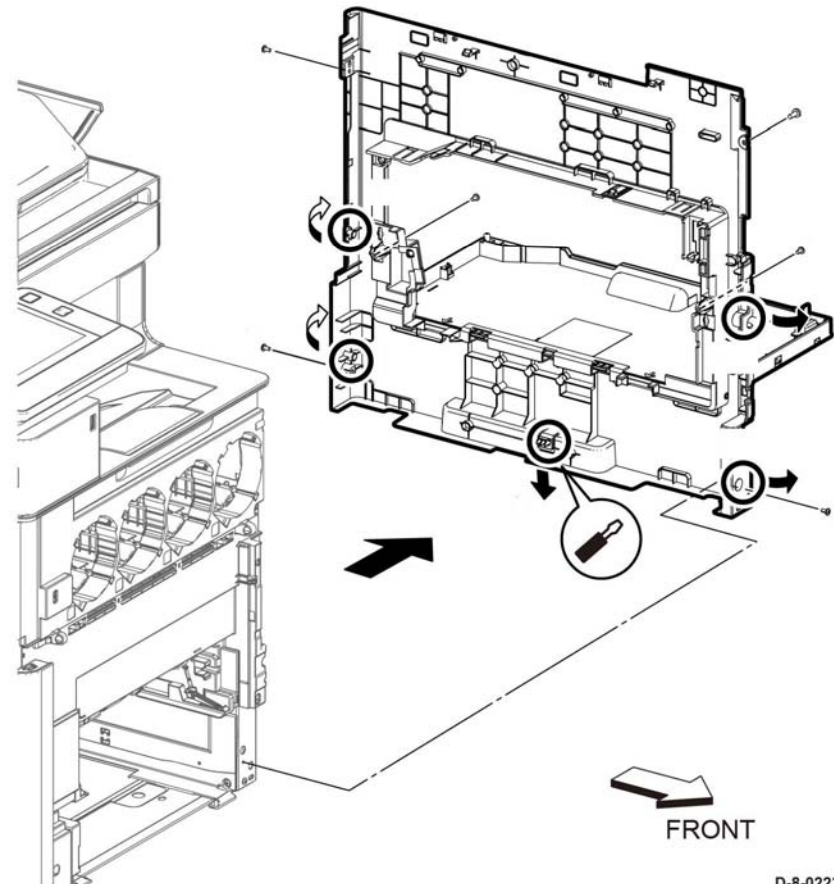
D-8-0223-B

3. Remove the items that follow, Figure 1:
  - One screw ST6.
  - Five screws ST18.
4. Perform the items that follow, Figure 1:
  - 4-1 Release one hook.
  - 4-2 Release one boss.
5. Release one hook at the bottom of the right side cover assembly, Figure 2.
6. Perform the items that follow, Figure 2:

- 6-1 Release one boss in the middle edge.
- 6-2 Release one boss on the bottom edge.
- 6-3 Remove the right side cover assembly.

Figure 2 Remove the right side cover assembly (SFP)

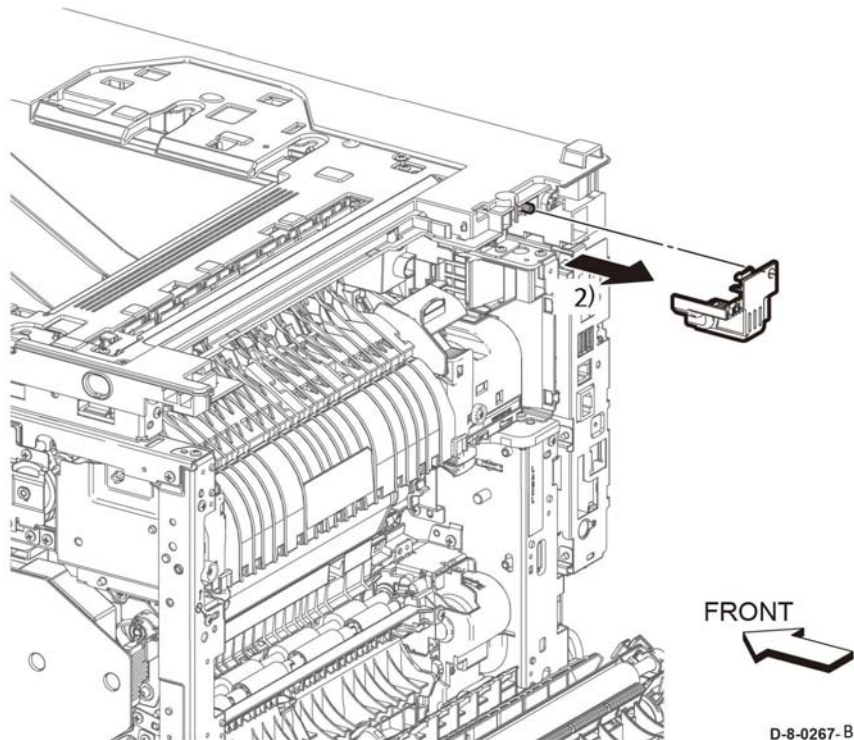
1. Open the rear cover assembly, [PL 19.2 Item 99](#).
2. Remove the OPT blind cover, [Figure 1](#):

Figure 1 Remove the OPT blind cover

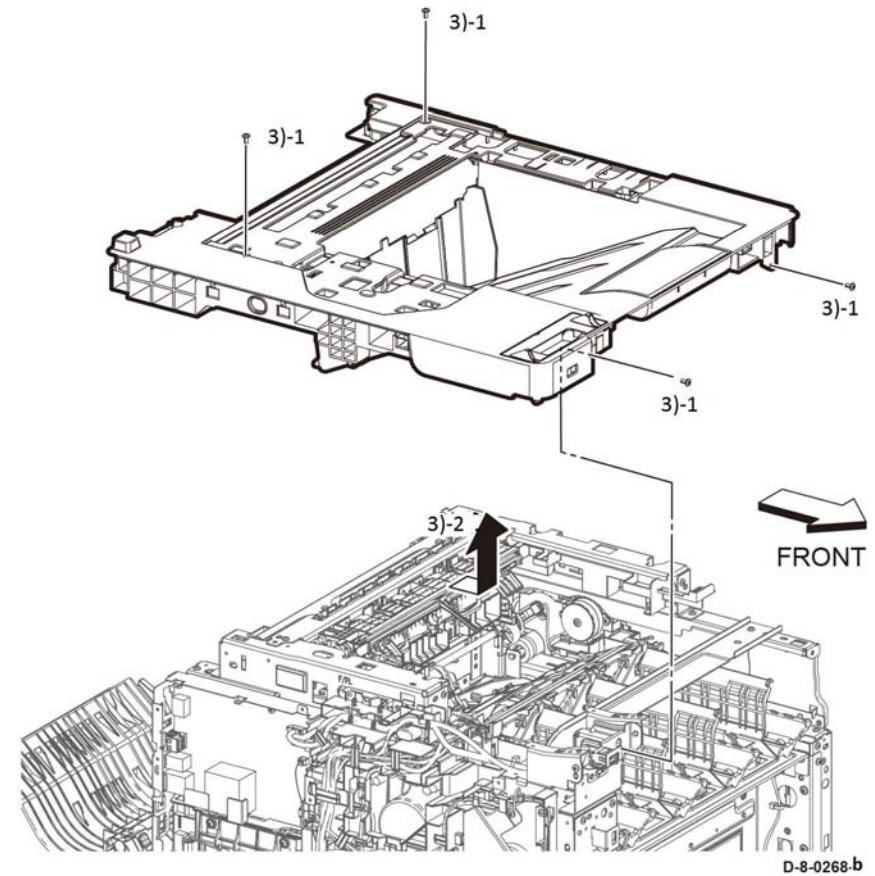
3. Perform the items that follow:
  - 3-1 Remove four screws SM18.

3-2 Remove the top cover assembly.

Figure 2 Remove top cover

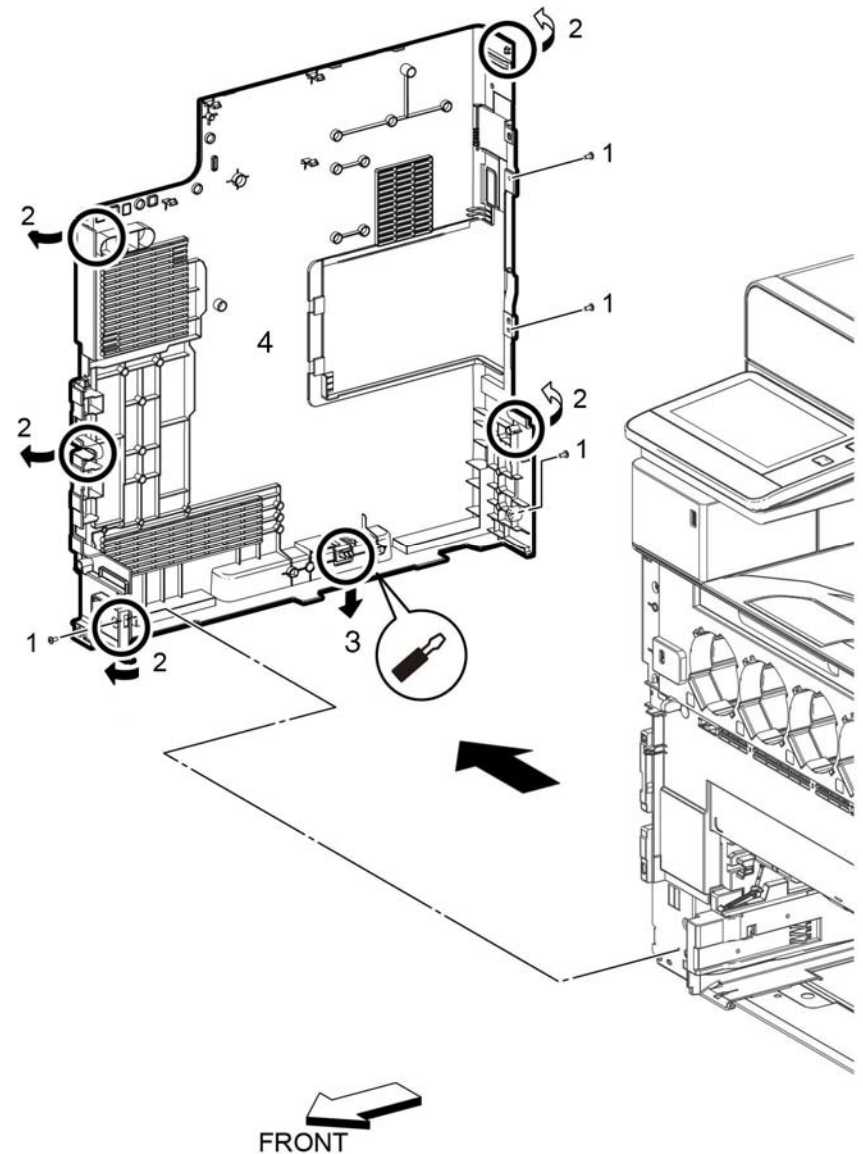
D-8-0225-b

1. Open the rear cover assembly, PL 19.1 Item 99.
2. Remove four screws SM 18
3. Release the items that follow, Figure 1:
  - 3-1 One hook.
  - 3-2 One hook.
  - 3-3 One boss.
4. Release one hook.
5. Perform the items that follow:
  - 5-1 Release one hook.
  - 5-2 Release one boss.
  - 5-3 Remove the left side cover.

Figure 1 Left side cover (SFP) removal

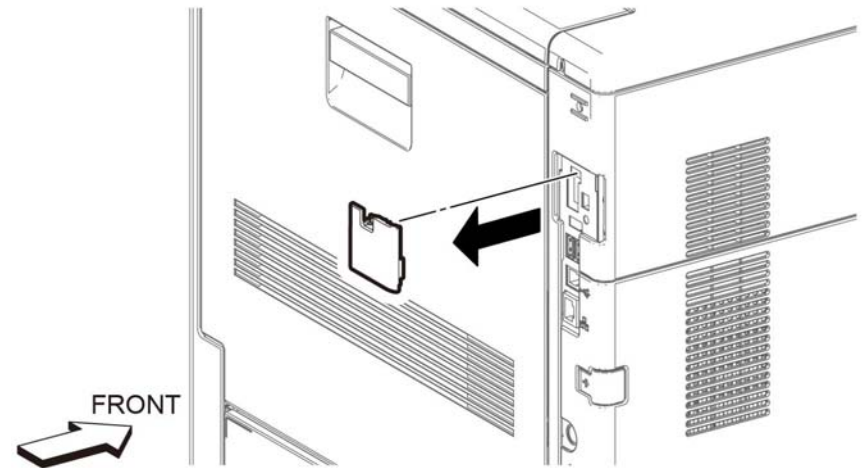
D-8-0278-A

1. Release the hook and remove the WIFI cap, [Figure 1](#).

Figure 1 WIFI cap (SFP) removal

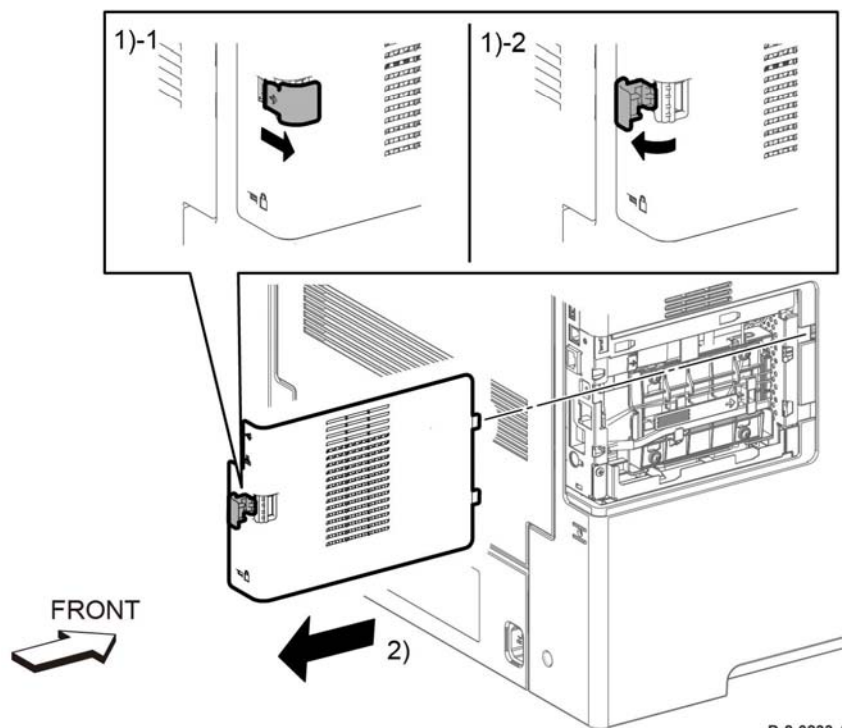
1. Perform the items that follow, [Figure 1](#):
  - 1-1 Slide the lever as shown.
  - 1-2 rotate the lever as shown.
2. Remove the ESS window assembly.

Figure 1 Remove the ESS window assembly (SFP)
