# VersaLink® B600/B610 Printer and B605/B615 Multifunction Printer Service Manual

Xerox® VersaLink® B600 Family MFP Service Manual

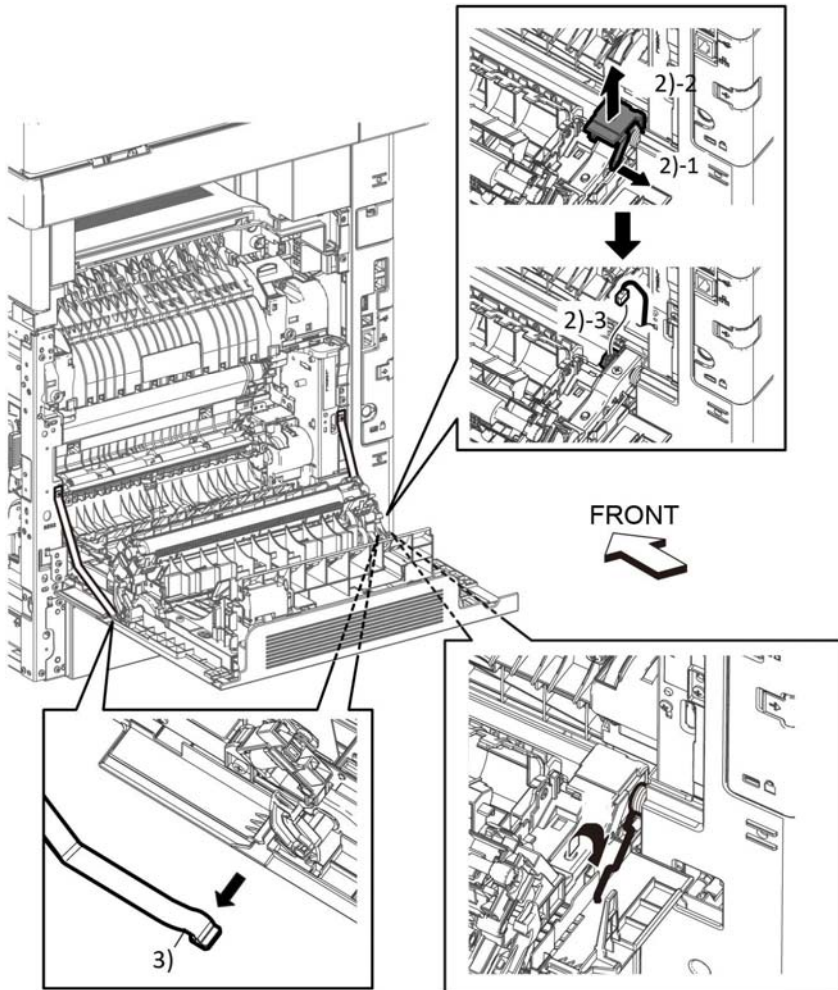
D-8-0227-B

1. Open the rear cover assembly.
2. Perform the items that follow, [Figure 1](#):
  - 2-1 Raise the lever.
  - 2-2 Remove the relay cover.
  - 2-3 Disconnect the connector, P/J296.
3. Release two rear cover straps

**Figure 1 Remove the rear cover assembly (SFP)**

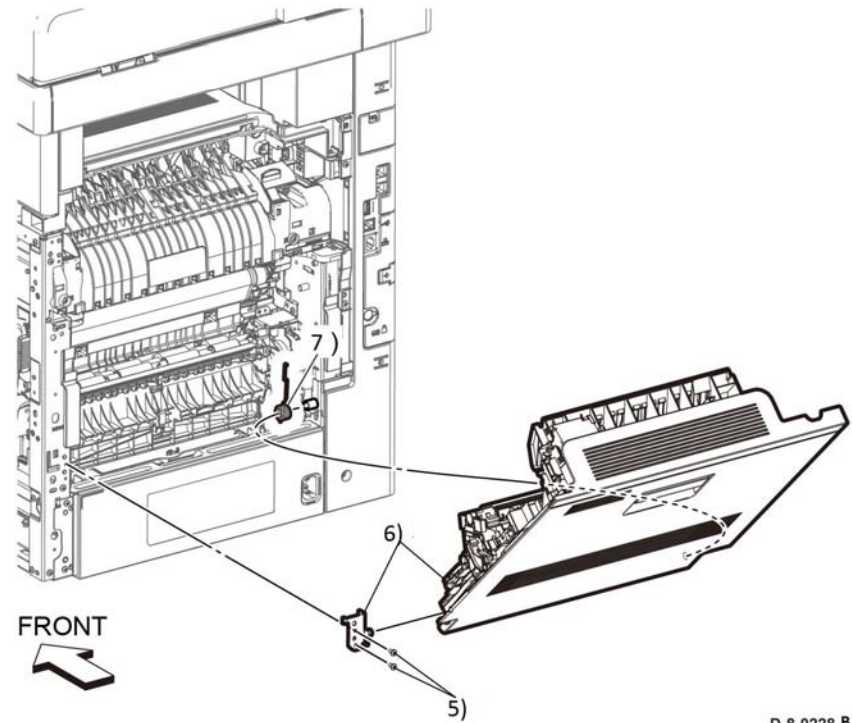
D-8-0228-B

4. Close the rear cover assembly.
5. Remove two screws, SM18, holding the right rear hinge assembly, [Figure 1](#).
6. Remove the right rear hinge assembly and the rear cover assembly.
7. Remove the rear cover spring.

**Figure 2 Remove the rear cover assembly (SFP)**

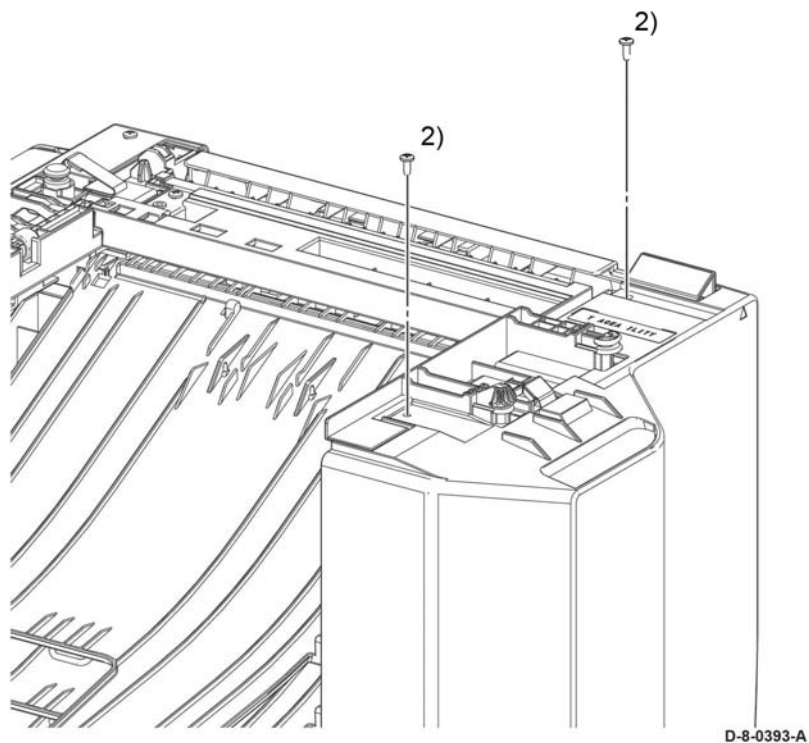
1. Remove the mailbox from the IOT, then turn the mailbox upside down.
2. Remove two screws SM20, [Figure 1](#).

Figure 1 Removing bottom screws

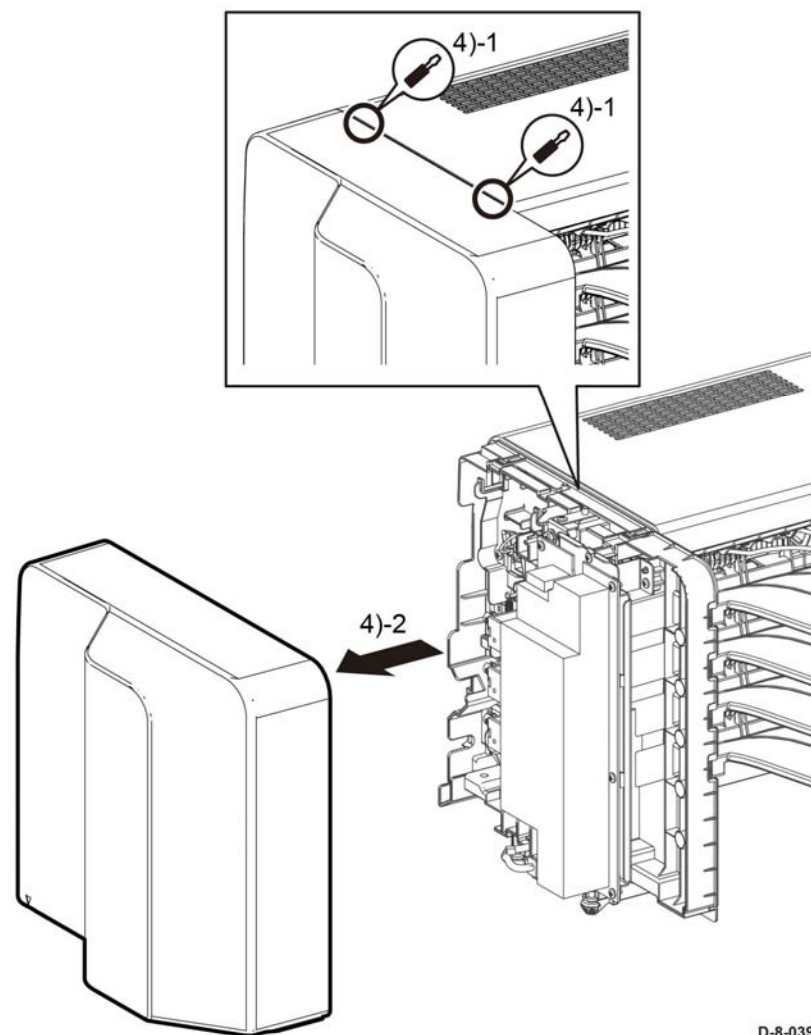
4-1 Release the two tabs.

4-2 Remove the cover LH C.

Figure 2 Removing cover LH C

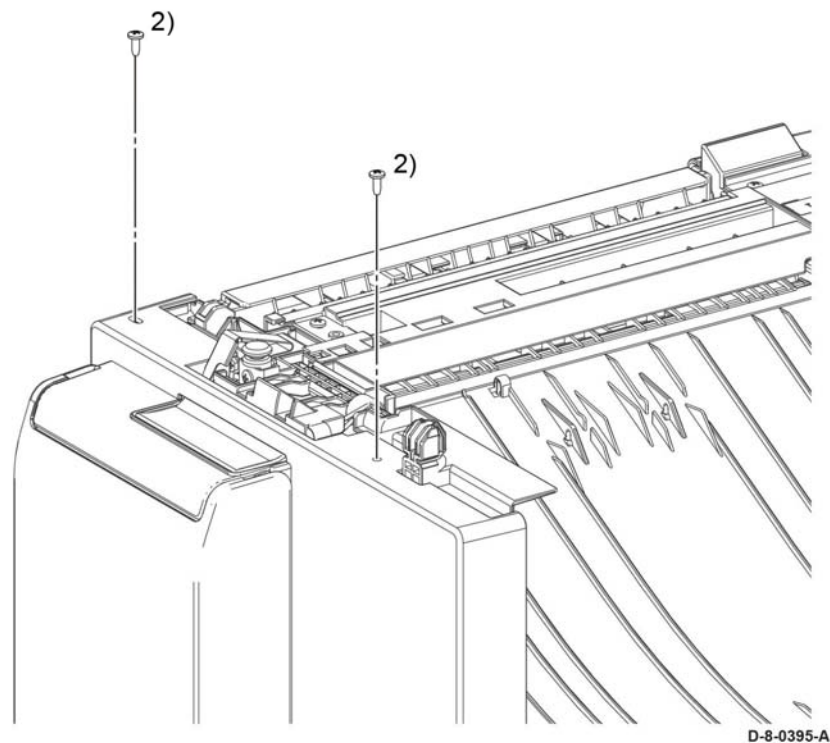
1. Remove the mailbox from the IOT, then turn the mailbox upside down.
2. Remove two screws SM20, [Figure 1](#).

Figure 1 right hand cover bottom screws

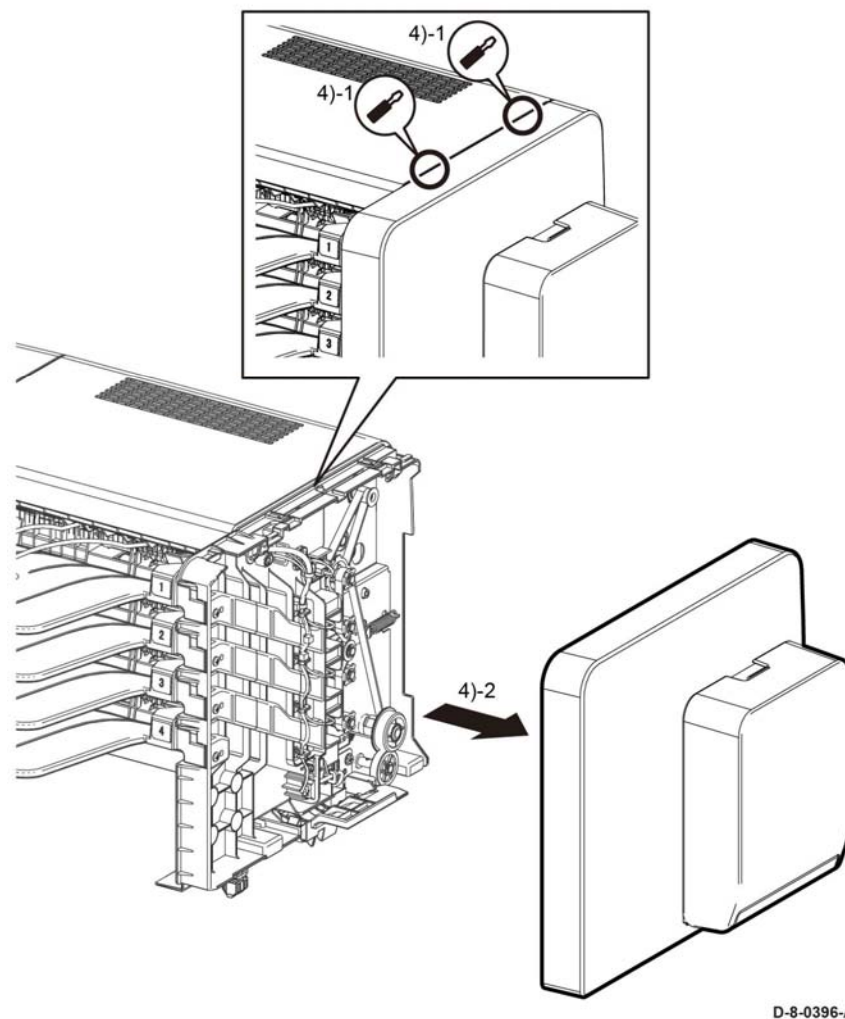
4-1 Release the two tabs.

4-2 Remove the cover RH C.

Figure 2 Cover removal

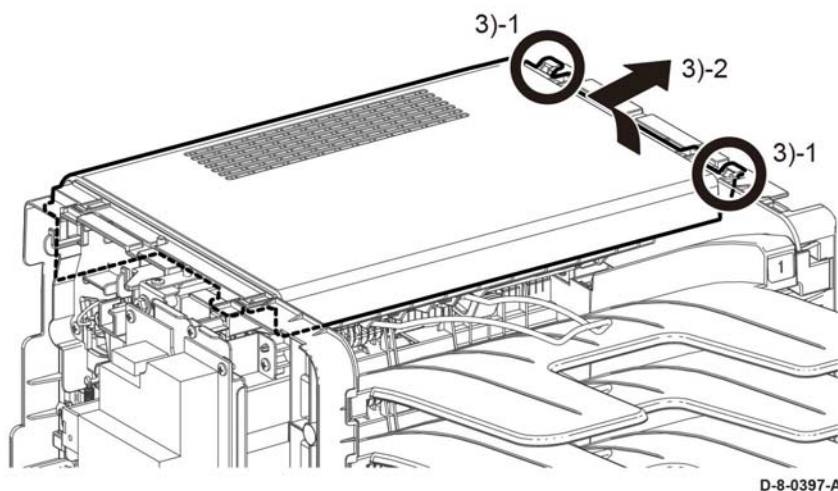
1. Remove the cover LH C, [REP 20.1](#).
2. Remove the cover RH C/cover assembly staple, [REP 20.2](#).
3. Perform the items that follow, [Figure 1](#):
  - 3-1 Use a flat blade screwdriver and release the two tabs.
  - 3-2 Remove the cover top C.

Figure 1 Cover top C removal

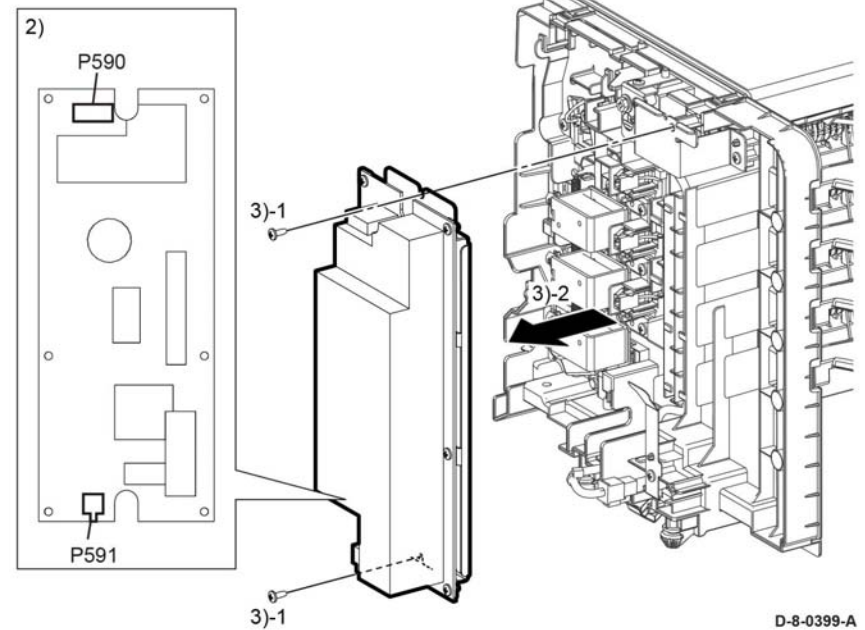
Figure 1 LVPS pwb

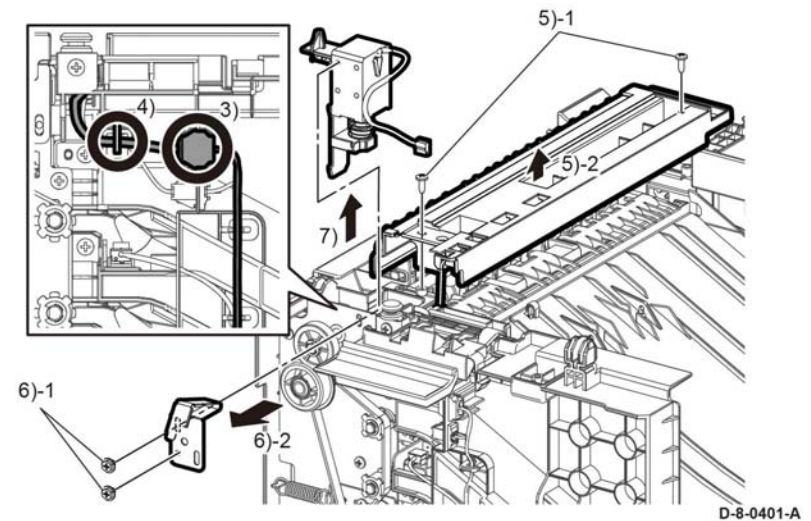
D-8-0401-A

Figure 1 Solenoid assembly gate

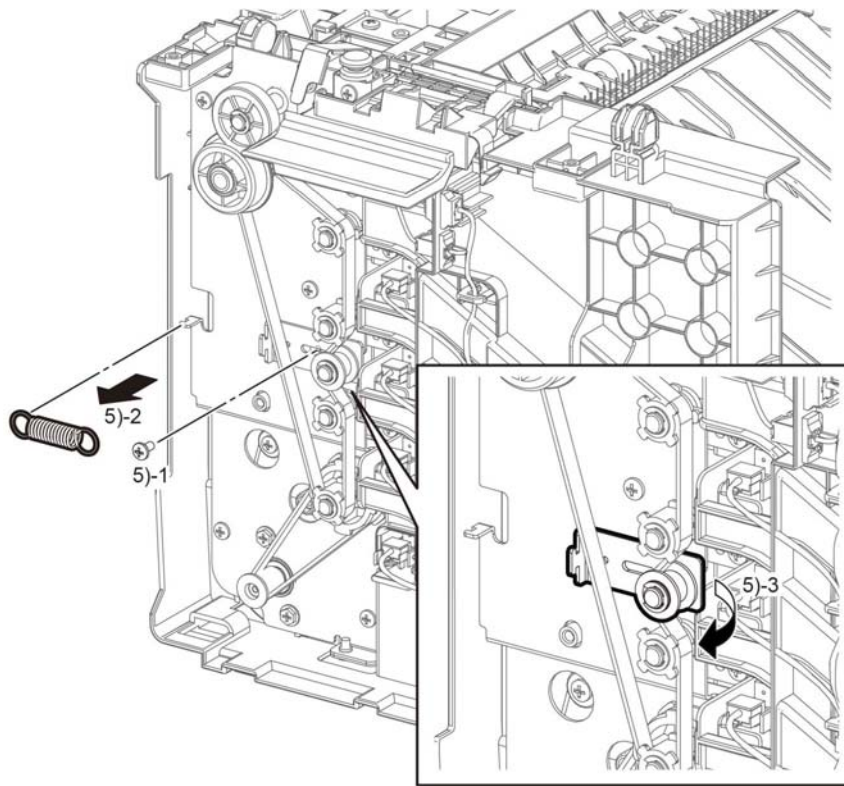
D-8-0402-A

1. Remove the cover LH C, [REP 20.1](#).
2. Remove the cover RH C/cover assembly staple, [REP 20.2](#).
3. Remove the tray assembly bottom, [REP 20.9](#).
4. Turn the mailbox up side down as shown in [Figure 1](#).
5. Remove the components that follow, [Figure 1](#):
  - 5-1 One screw, SM18.
  - 5-2 Spring tension, [PL 20.2 Item 16](#).
  - 5-3 Bracket assembly tension, [PL 20.2 Item 17](#).
  - 5-4 Pulley tension spring, [PL 20.2 Item 16](#).

**Figure 1 Tension pulley**

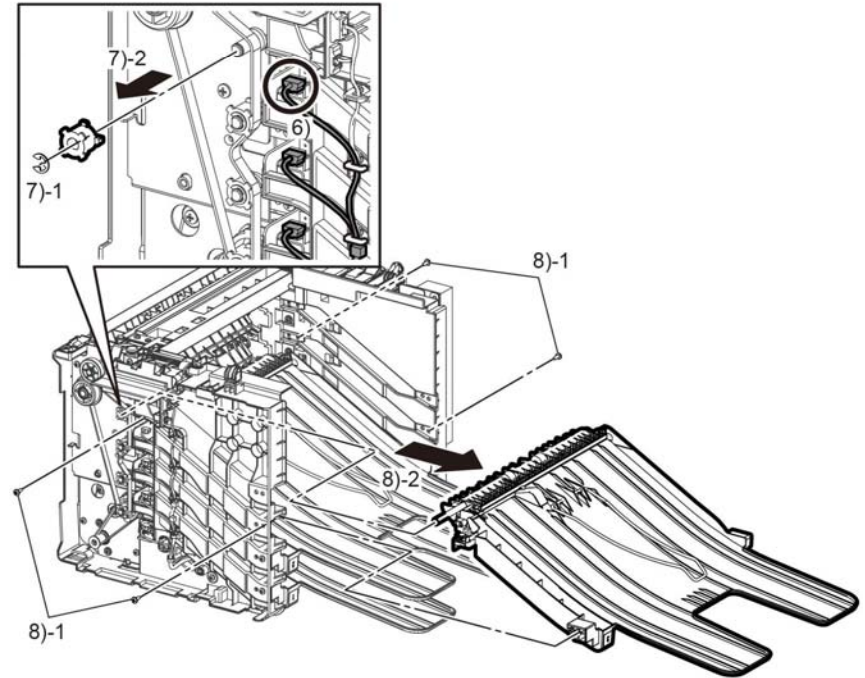
D-8-0403-A

6. Disconnect the connector P/J8334, [Figure 2](#).
7. Remove the items that follow, [Figure 2](#):
  - 7-1 E-ring.
  - 7-2 Pulley, T20 MBX and Bushing while releasing the belt.
8. Remove the items that follow, [Figure 2](#):
  - 8-1 Four screws, ST20.
  - 8-2 3rd tray assembly, [PL 20.1 Item 2](#).

**Figure 2 3rd tray assembly**

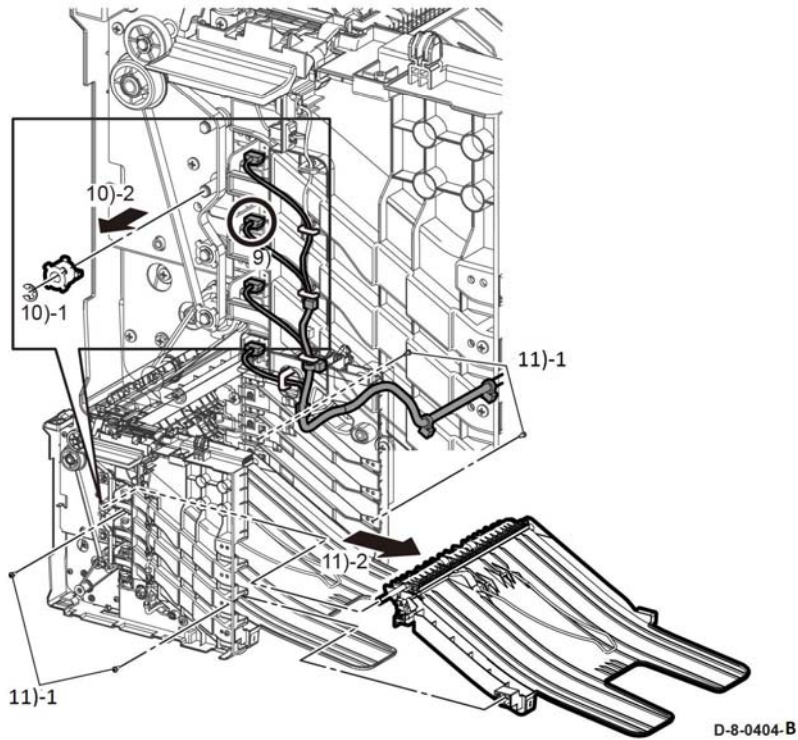
9. Disconnect connector P/J8933, [Figure 3](#).
10. Remove the items that follow, [Figure 3](#):
  - 10-1 E-ring.
  - 10-2 Pulley T20 MBX while avoiding the belt.
11. Remove the items that follow, [Figure 3](#):
  - 11-1 Four screws, ST20.
  - 11-2 2nd tray assembly, [PL 20.1 Item 2](#).

Figure 3 2nd tray assembly

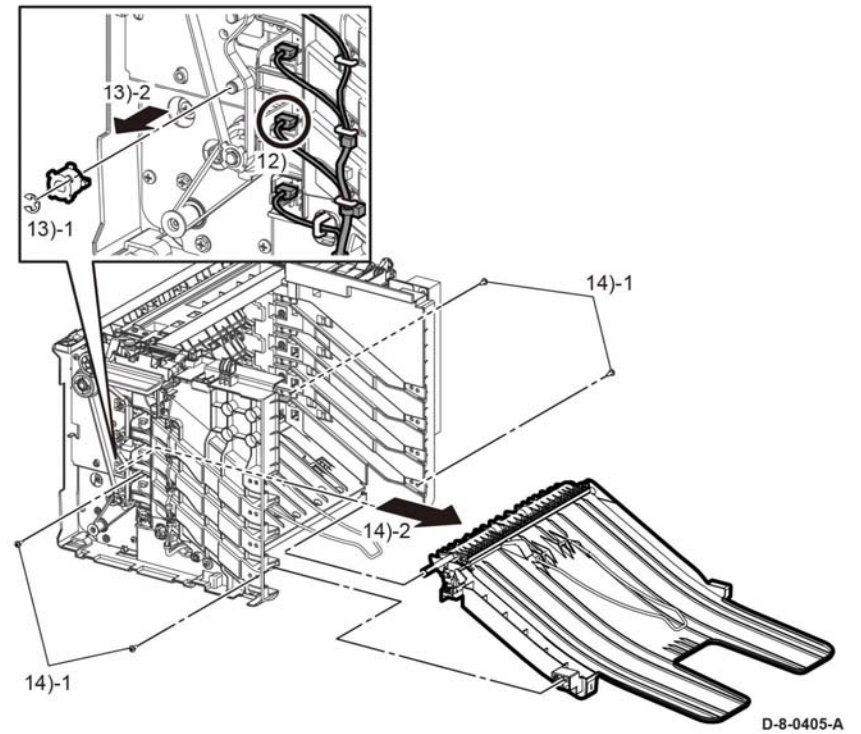
Figure 4 1st tray assembly

12. Disconnect connector P/J8932, [Figure 4](#).
13. Remove the components that follow, [Figure 4](#):
  - 13-1 E-ring.
  - 13-2 Pulley T20 MBX while releasing the belt.
14. Remove the components that follow, [Figure 4](#):
  - 14-1 Four screws, ST20.
  - 14-2 1st tray assembly, [PL 20.1 Item 2](#).

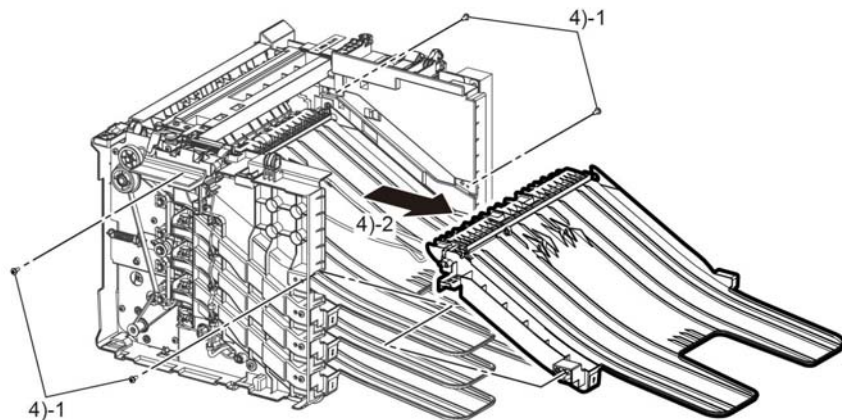
D-8-0406-A

1. Remove the cover LH C, [REP 20.1](#).
2. Remove the cover RH c/cover assembly staple, [REP 20.2](#).
3. Turn the mailbox upside down as shown in [Figure 1](#).
4. Remove the items that follow, [Figure 1](#):
  - 4-1 Four screws, ST20.
  - 4-2 Tray assembly bottom, [PL 20.1 Item 3](#).

Figure 1 Tray assembly bottom

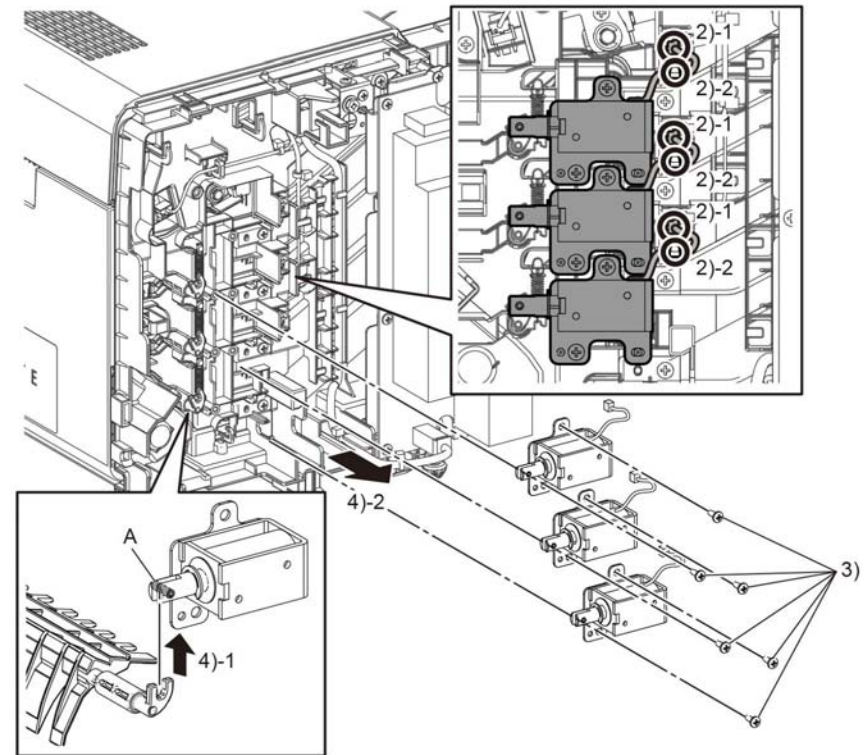
D-8-0407-A

1. Remove the cover LH C, [REP 20.1](#).
2. Perform the items that follow, [Figure 1](#):
  - 2-1 Remove the connector from defective bin gate solenoid P/J8940, or P/J8941, or P/J8942.
  - 2-2 Release the harness from the harness guides
3. Remove two screws, ST20, from the defective bin gate solenoid.
4. Perform the items that follow, [Figure 1](#):
  - 4-1 Disengage the link arm from the defective bin gate solenoid.
  - 4-2 Remove bin assembly gate solenoids.

Figure 1 Bin assembly gate solenoids

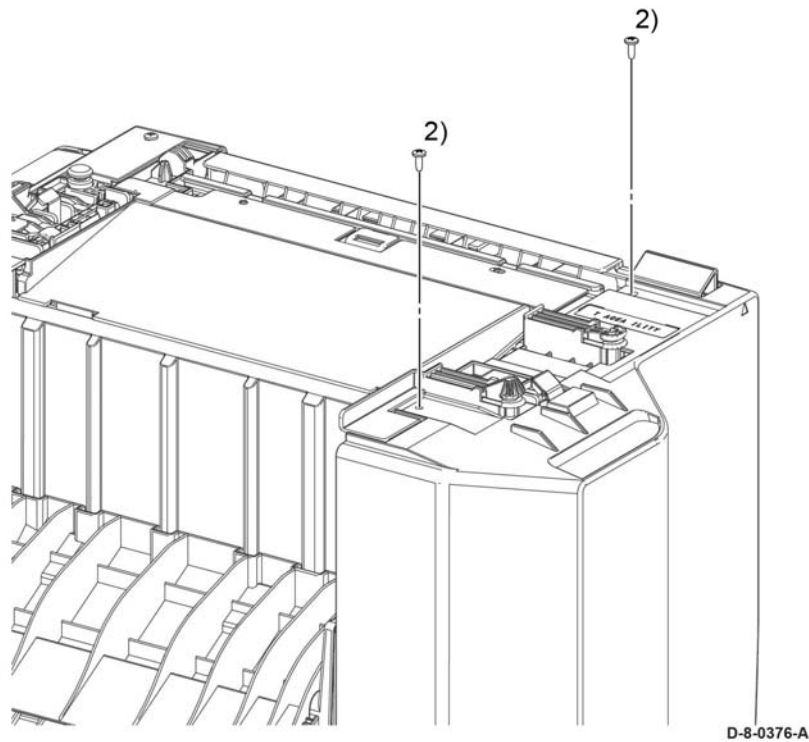
2. Remove two screws, ST20, [Figure 1](#).

Figure 1 Removing bottom screws

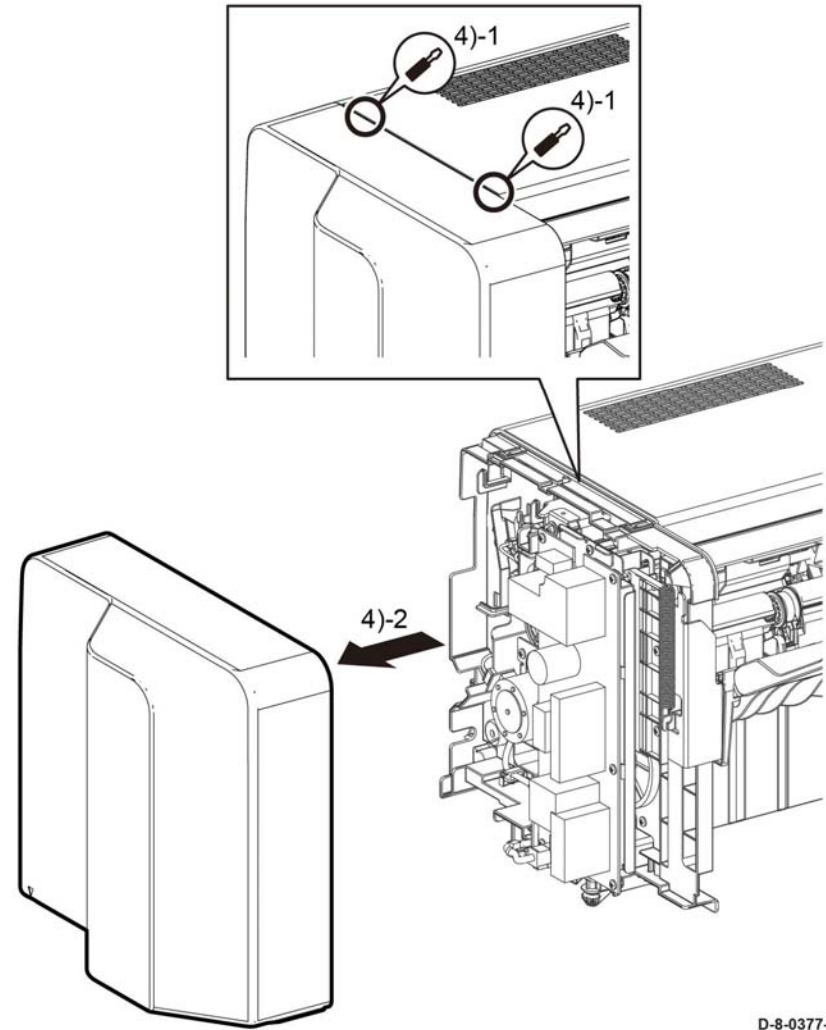
3. Turn the finisher right side up.
4. Perform the steps that follow, [Figure 2](#):
  - 4-1. Use a flat blade screwdriver to release the two tabs.
  - 4-2. Remove the cover LH C.

Figure 2 Cover LH C removal

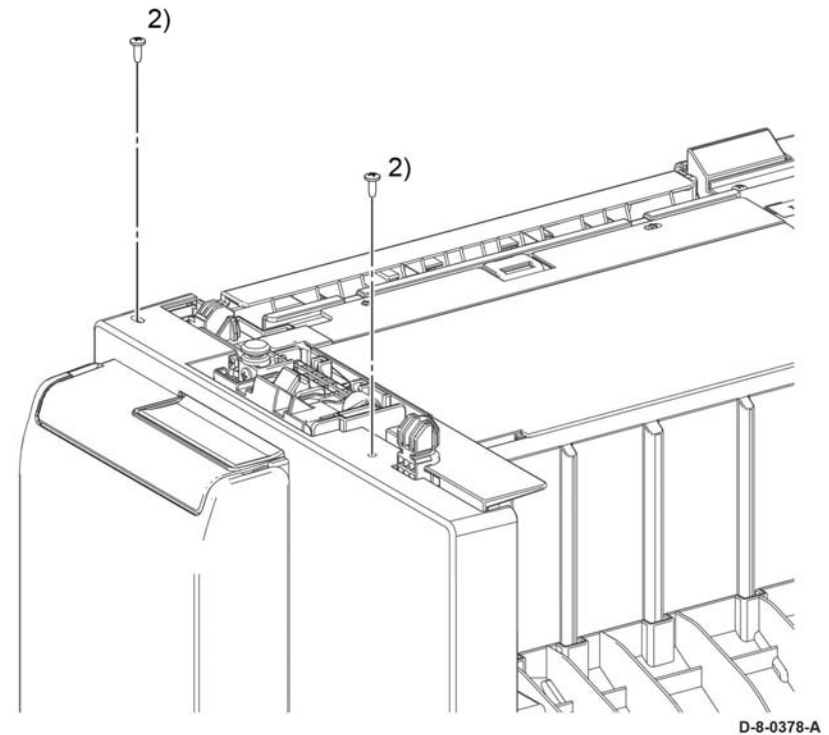
1. Perform the steps that follow:
  - Remove the finisher.
  - Turn the finisher upside down.
2. Remove two screws, ST20, [Figure 1](#).

Figure 1 Right hand cover bottom screws

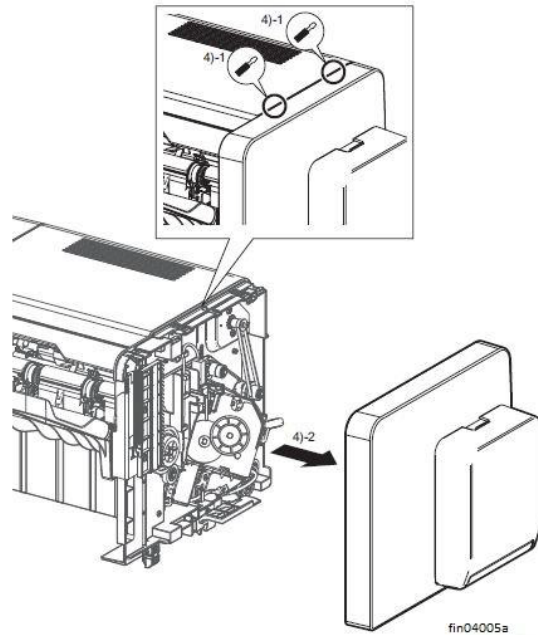
3. Turn the finisher right side up.
4. Perform the steps that follow, [Figure 2](#).
  - 4-1 Insert a flat blade screwdriver to release the two tabs.
  - 4.2 Remove the cover RH C.

Figure 2 Cover removal

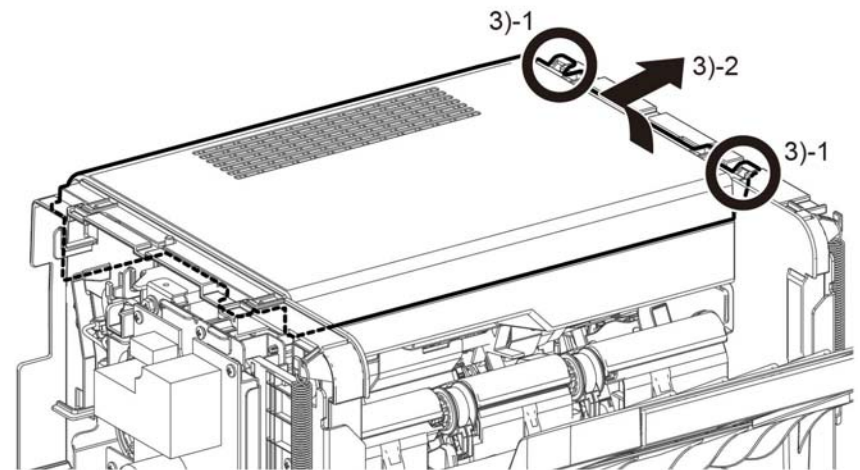
1. Remove the cover LH C, [REP 21.1](#).
2. Remove the cover RH C, [REP 21.2](#).
3. Perform the items that follow, [Figure 1](#):
  - 3-1 Release two tabs.
  - 3-2 Remove the top cover C.

Figure 1 Cover top C removal

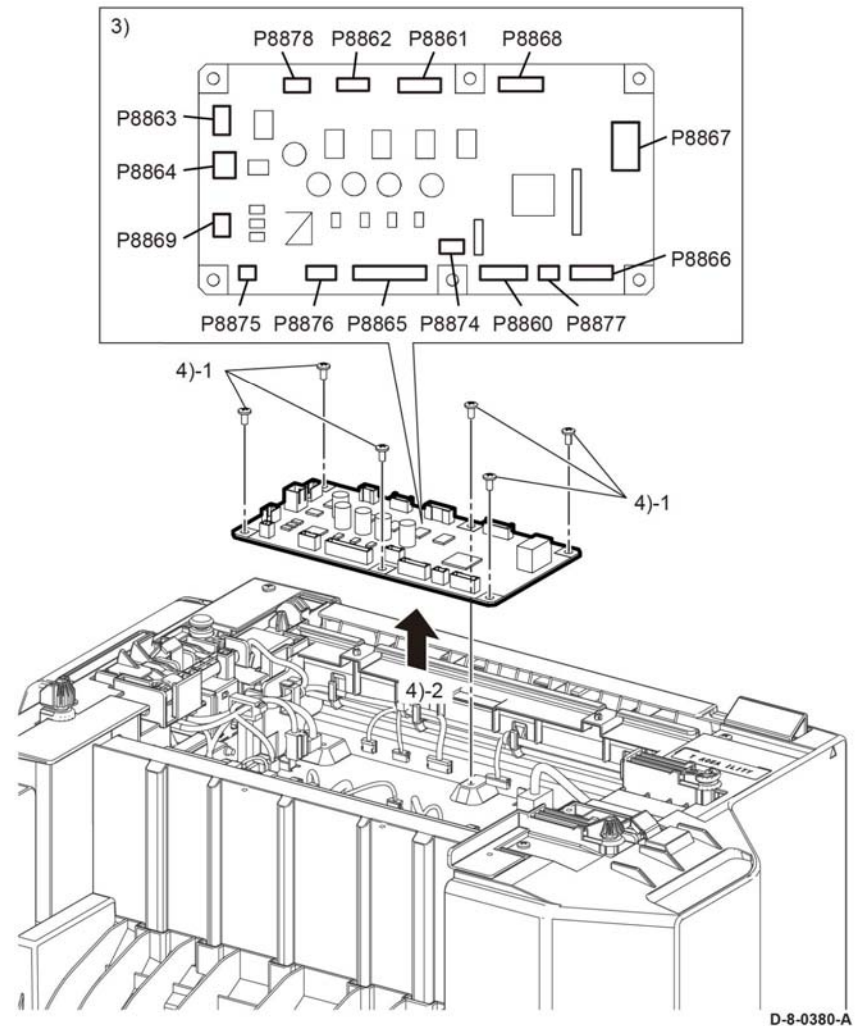
1. Remove the cover lower C, [REP 21.8](#).
2. Turn the finisher upside down.
3. Disconnect all connectors, [Figure 1](#).
4. Remove the components that follow:
  - 4-1 Six screws, SM18.
  - 4-2 PWB GPF A4 finisher.

Figure 1 PWB removal

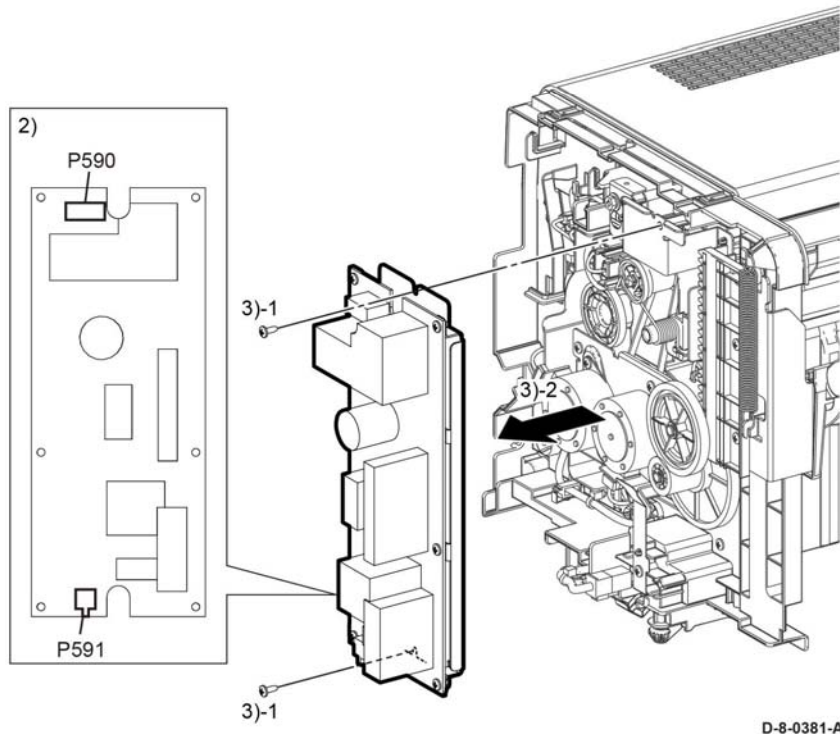
D-8-0381-A

1. Remove the cover LH C, [REP 21.1](#).
2. Disconnect two connectors, P/J590, P/J591, [Figure 1](#).
3. Remove the components that follow:
  - 3-1 Two screws, ST20.
  - 3-2 LVPS.

Figure 1 LVPS removal

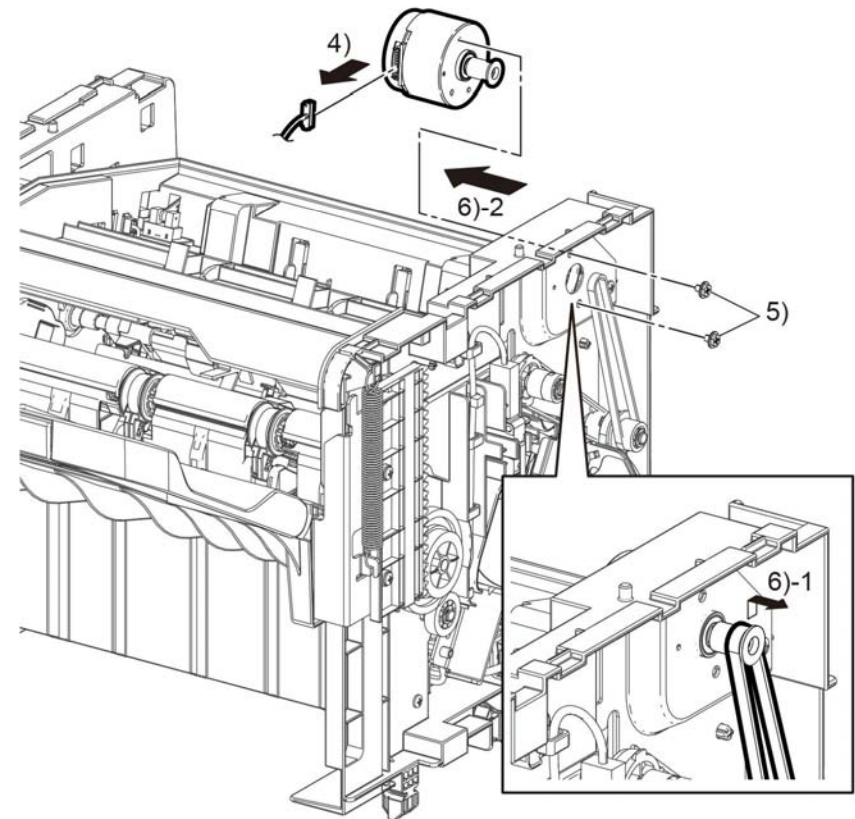
D-8-0382-A

1. Remove the cover LH C, [REP 21.1](#).
2. Remove the cover RH C/cover assembly staple, [REP 21.2](#).
3. Remove the cover top C, [REP 21.3](#).
4. Disconnect the connector, P/J9810, [Figure 1](#).
5. Remove two screws, SM25, [Figure 1](#).
6. Remove the components that follow, [Figure 1](#):
  - 6-1 Belt.
  - 6-2 Motor.

Figure 1 Motor assembly

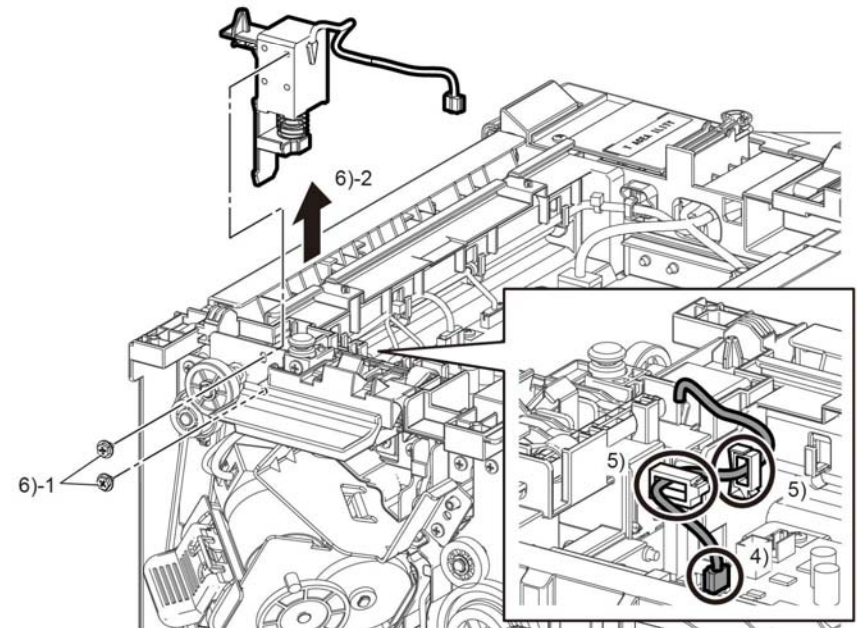
D-8-0383-A

1. Remove the cover RH C, [REP 21.2](#).
2. Remove the Cover lower C, [REP 21.8](#).
3. Turn the finisher upside down as shown in [Figure 1](#).
4. Disconnect the connector P/J8869.
5. Release the solenoid assembly gate harness from the two clamps, [Figure 1](#).
6. Remove the components that follow, [Figure 1](#):
  - 6-1 Two screws, SM25.
  - 6-2 Solenoid assembly gate.

Figure 1 Solenoid gate assembly removal

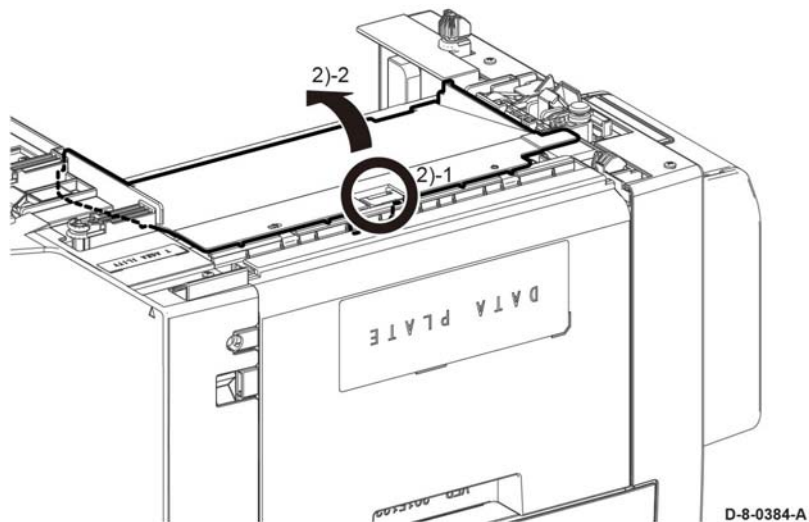
1. Remove the finisher, REP TBD. Turn the finisher upside down.
2. Perform the items that follow, [Figure 1](#):
  - 2-1 Press the release lever.
  - 2-2 Remove the cover lower C.

Figure 1 Cover lower C removal

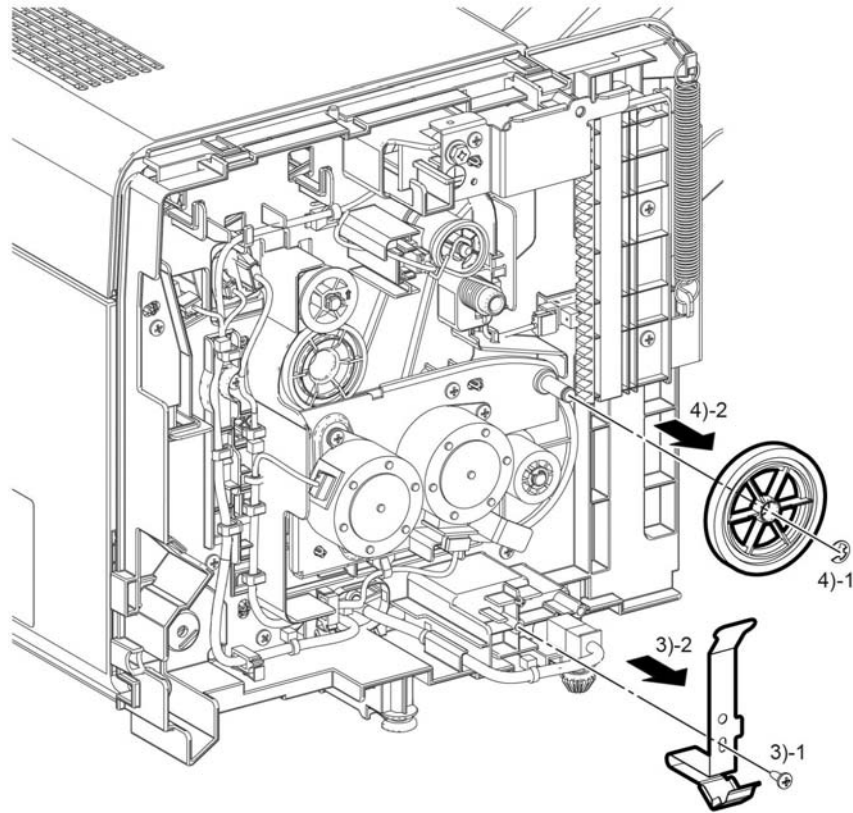
D-8-0385-A

1. Remove the cover LH C, [REP 21.1](#).
2. Remove the LVPS, [REP 21.8](#).
3. Remove the components that follow, [Figure 1](#):
  - 3-1 One screw, ST20.
  - 3-2 Plate ground LH bracket.
4. Remove the components that follow, [Figure 1](#):
  - 4-1 One E-ring.
  - 4-2 Gear.

**Figure 1 Motor gear and bracket removal**

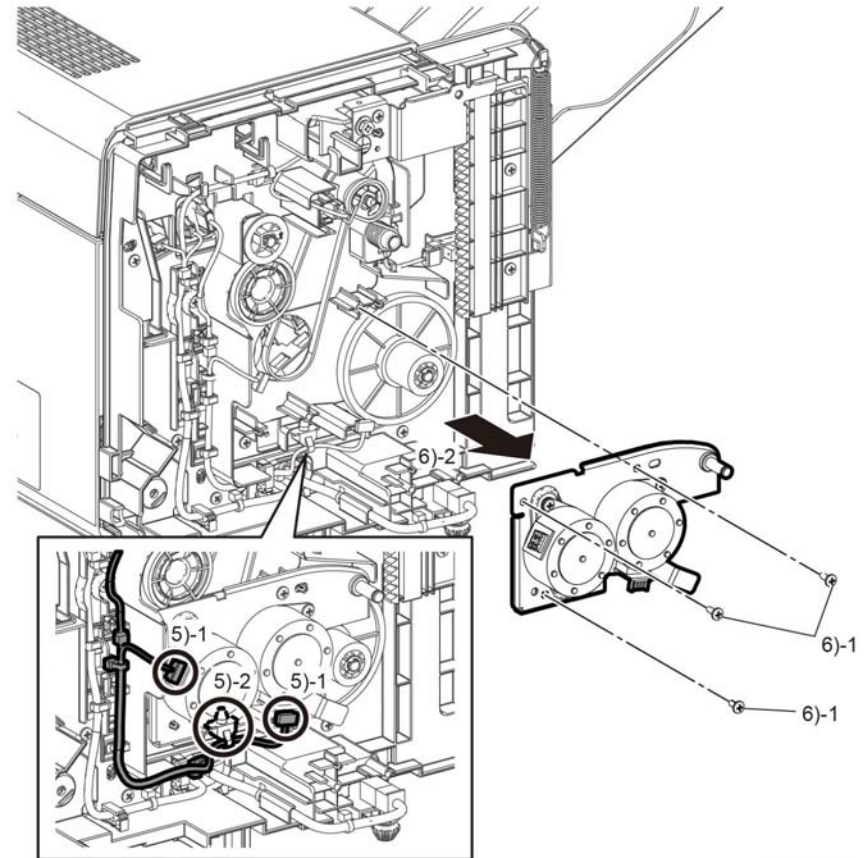
D-8-0386-A

5. Perform the steps that follow, [Figure 2](#):
  - 5-1 Disconnect two connectors, P/J8906, P/J8907.
  - 5-2 Release the wire holder.
6. Remove the components that follow, [Figure 2](#):
  - 6-1 Two screws, ST20.
  - 6-2 One screw, SM18.
  - 6-3 Motor assembly stepping, [Figure 2](#).

**Figure 2 Motor assembly removal**

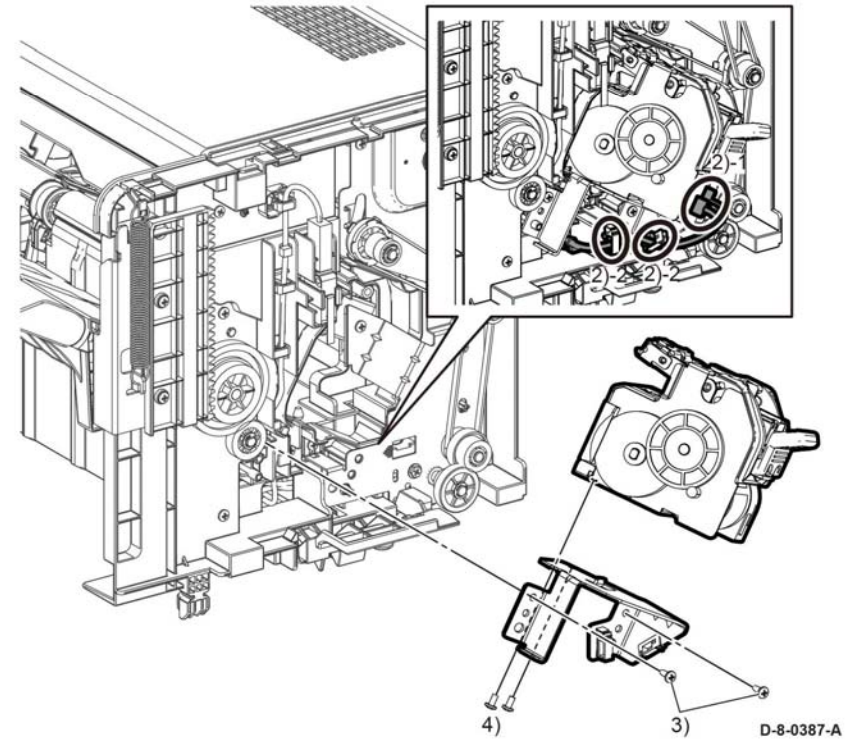
1. Remove the Cover RH C, [REP 21.2](#).
2. Perform the steps that follow, [Figure 1](#):
  - 2-1 Disconnect connectors P/J8897,P/J9808.
  - 2-2 Release the harness from the clamps.
3. Remove the components that follow, [Figure 1](#):
  - 3-1 Two screws, ST20, harness Kit.
  - 3-2 Stapler assembly with the bracket assembly.
4. Remove the components that follow, [Figure 1](#):
  - 4-1 Two screws SM4.
  - 4-2 Bracket from the stapler assembly.

Figure 1 Stapler and bracket removal

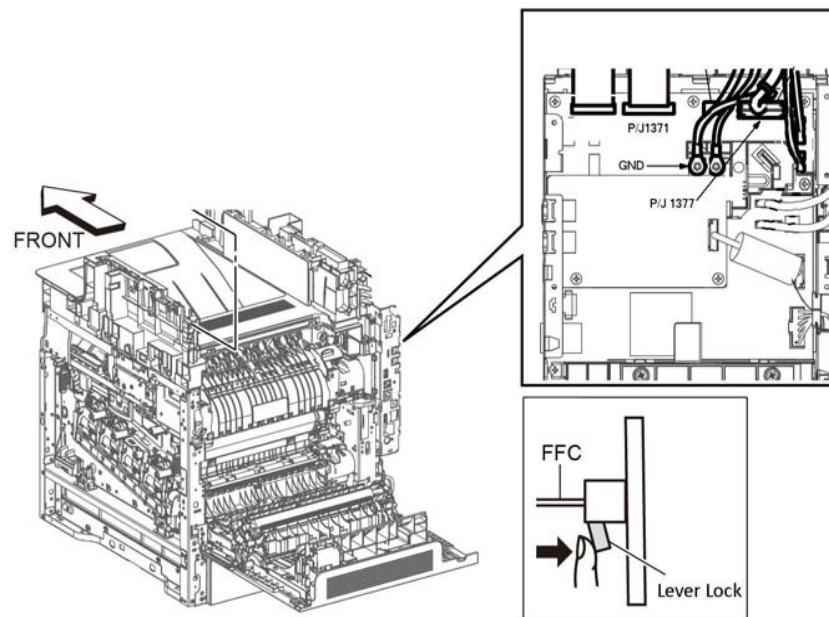
D-8-0198-B

NOTE: When engaging the release lever on the FFC connector, slightly press open the release lever no more than 15 degrees. Hold the lever while gently removing the FFC from the connector as shown in the inset of [Figure 1](#), Disconnect the DADF harness and FFC.

1. Refer to [Figure 1](#), following the caution above, release the FFC (P/J1371) coming from the DADF, disconnect (P/J1377), and the ground wire from the ESS PWB, [PL 18.1 Item 3](#).

Figure 1 Disconnect the DADF harness and FFC (MFP Std.)

2. Refer to [Figure 1](#), release the hook and remove the FFC Cover from the IIT Assembly.
3. Refer to [Figure 1](#), remove the DADF harness out of its harness guide and up through the IIT Assembly.
  - a. Fold the DADF harness connector up against the wires.
  - b. Orient the harness connector to face the front of the printer.
  - c. Pass the harness up through the IIT Assembly.
4. Refer to [Figure 2](#), lift the DADF assembly straight up from the IIT assembly in the direction of the arrow.

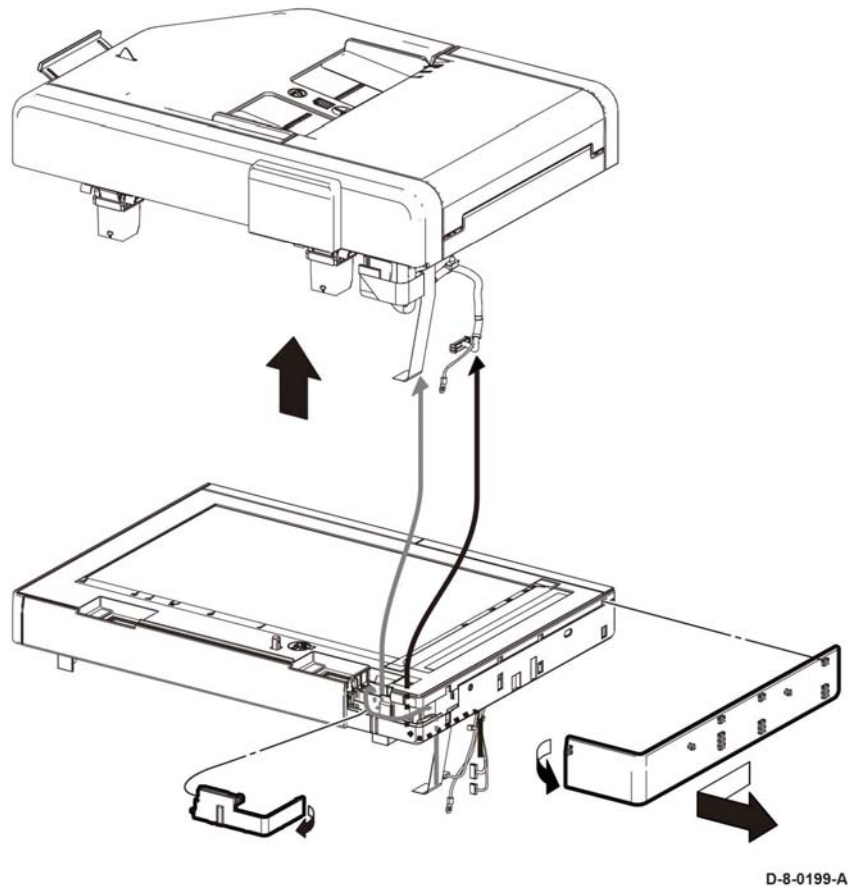
Figure 2 Separate the DADF Assembly from the IIT

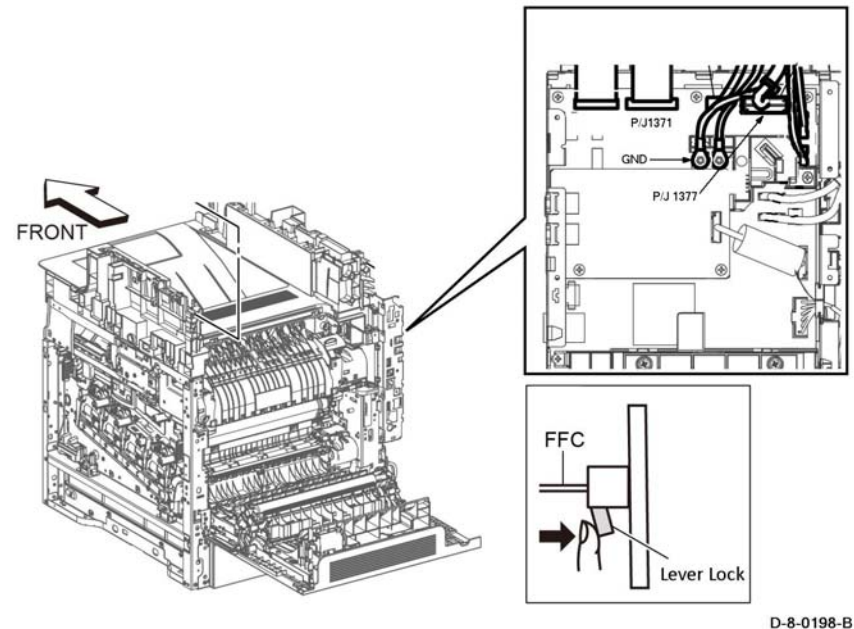
NOTE: When engaging the release lever on the FFC connector, slightly press open the release lever no more than 15 degrees. Hold the lever while gently removing the FFC from the connector as shown in the inset of Figure 3, Disconnect the DADF harness and FFC.

1. Refer to Figure 3, following the caution above, release the FFC (P/J1371) coming from the DADF, disconnect (P/J1377), and the ground wire from the ESS PWB, PL 18.1 Item 3.

Figure 3 Disconnect the DADF harness and FFC (MFP Tall)

2. Refer to Figure 3, release the hook and remove the FFC Cover from the IIT Assembly.
3. Refer to Figure 4, remove the DADF harness out of its harness guide and up through the IIT Assembly.
  - a. Fold the DADF harness connector up against the wires.
  - b. Orient the harness connector to face the front of the printer.

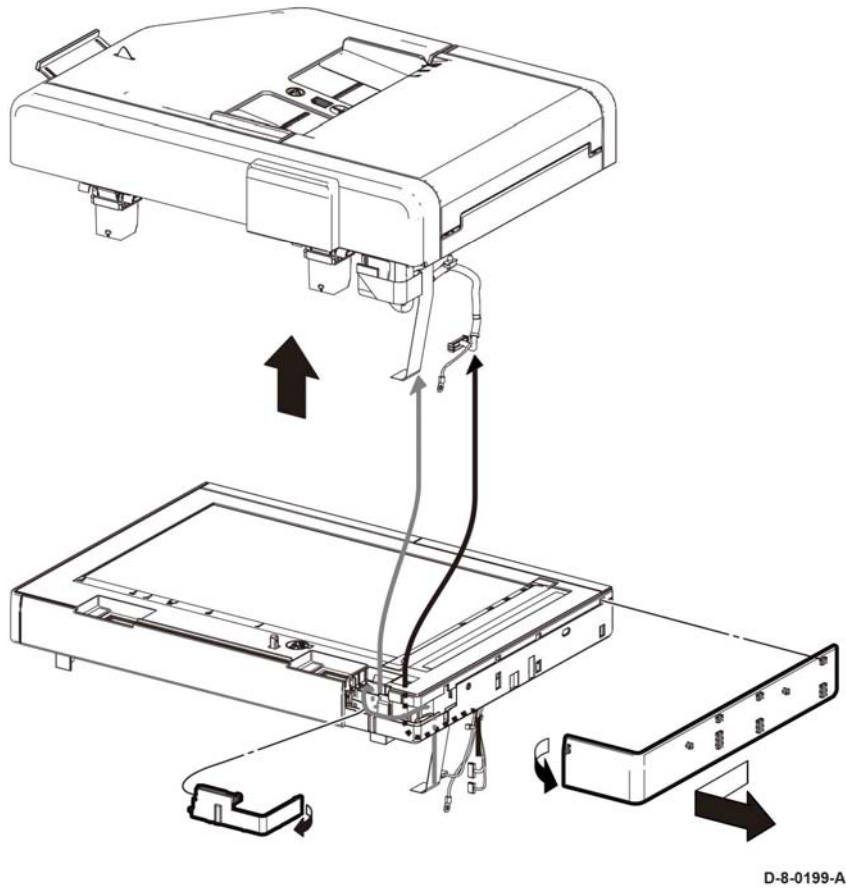
- c. Pass the harness up through the IIT Assembly.
- 4. Refer to [Figure 4](#), lift the DADF assembly straight up from the IIT assembly in the direction of the arrow.

Figure 4 Separate the DADF Assembly from the IIT

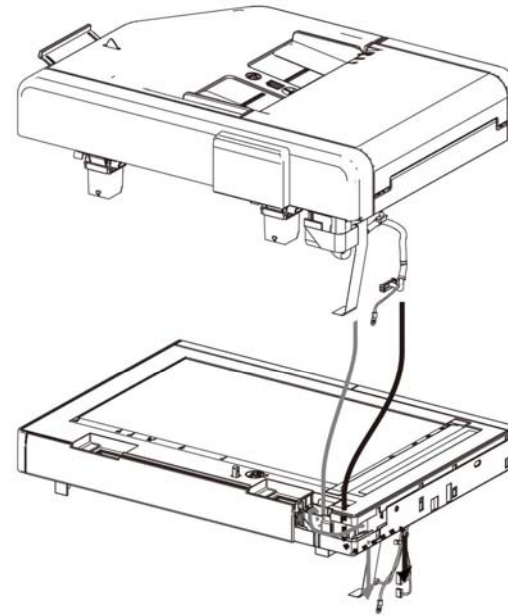
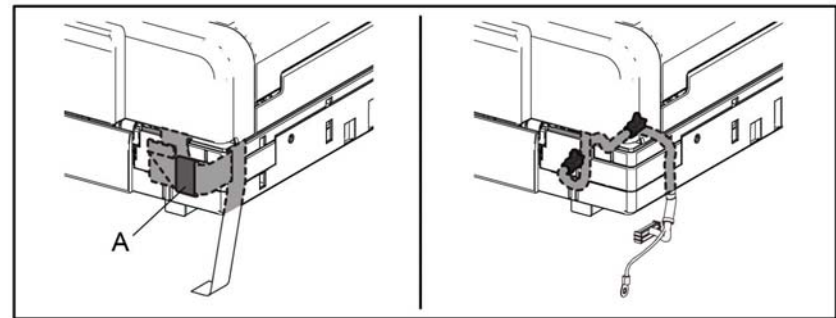
D-8-0201-A

Avoid pinching wires when installing the DADF harness and FFC. Be sure to follow the harness routes as shown in [Figure 5](#).

Figure 5 DADF Harness Routes
