# VersaLink® B600/B610 Printer and B605/B615 Multifunction Printer Service Manual

Xerox® VersaLink® B600 Family MFP Service Manual

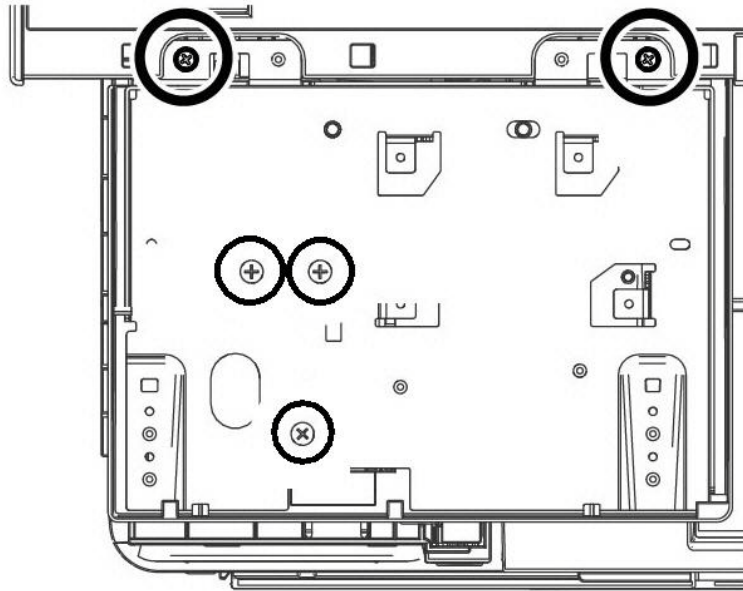
D-8-0014-B

1. Remove the IOT 550 cassette assembly, [PL 19.1 Item 1](#).
2. Remove the main MSI tray assembly, [PL 13.2 Item 1](#).
3. Open the rear door.
4. Remove the ESS window assembly kit, [PL 19.2 Item 13](#).
5. Remove the WiFi cap, [PL 19.2 Item 16](#).
6. Remove the L front cover, [PL 19.1 Item 22](#).
7. Remove the L side cover, [PL 19.2 Item 1](#).
8. Remove the Cover Front IIT, [PL 50.1.19](#).
9. Remove the UI inner cover, [PL 1.1 Item 2](#).
10. Remove the top ESS plate, [PL 18.1 Item 18](#).
11. Refer to [Figure 1](#), remove 2 screws connecting the UI plate to the scanner and three screws in the UI plate.

Figure 1 UI plate screw locations

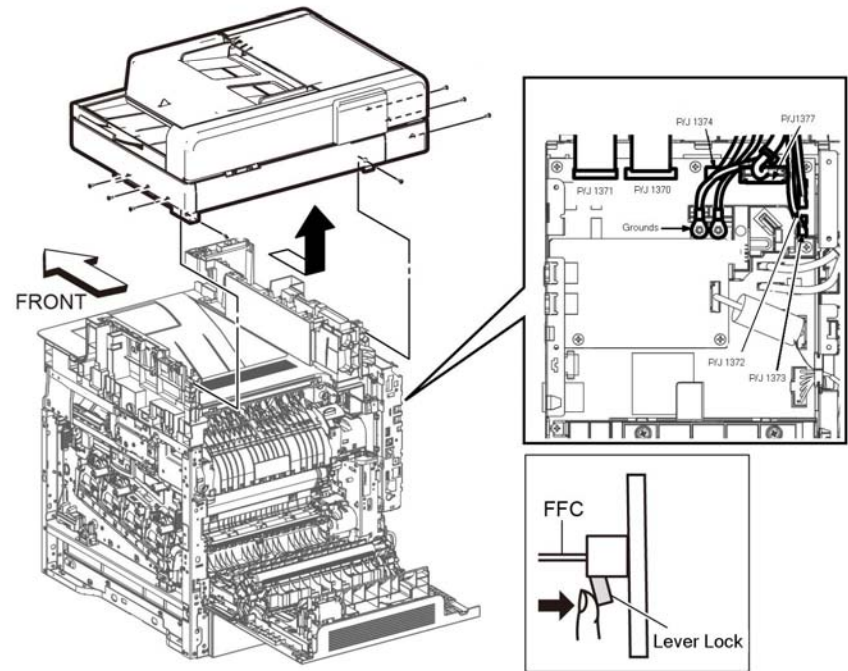
D-8-0198-C

12. Refer to Figure 2, following the caution above, release the 2 FFC cables (P/J1370 and P/J1371) and disconnect (P/J1372, P/J1373, P/J1374, P/J1377) from the ESS PWB.
13. Refer to Figure 2, remove two screws (SM18, silver, M3X6mm) to release the ground harnesses from the ESS PWB, PL 18.1 Item 3.
14. Release three clamps and five push-ties.
15. Refer to Figure 2, remove eight screws (SM18, silver, M3X6mm) to remove the scanner assembly PL 50.1 Item 13 in the direction of the arrow.

Figure 2 Disconnect the harnesses and two FFCs (MFP Std.)

*NOTE: When engaging the release lever on the FFC connector, slightly press open the release lever no more than 15 degrees. Hold the lever while gently removing the FFC from the connector as shown in the inset of Figure 2, Disconnect the harnesses and two FFCs.*

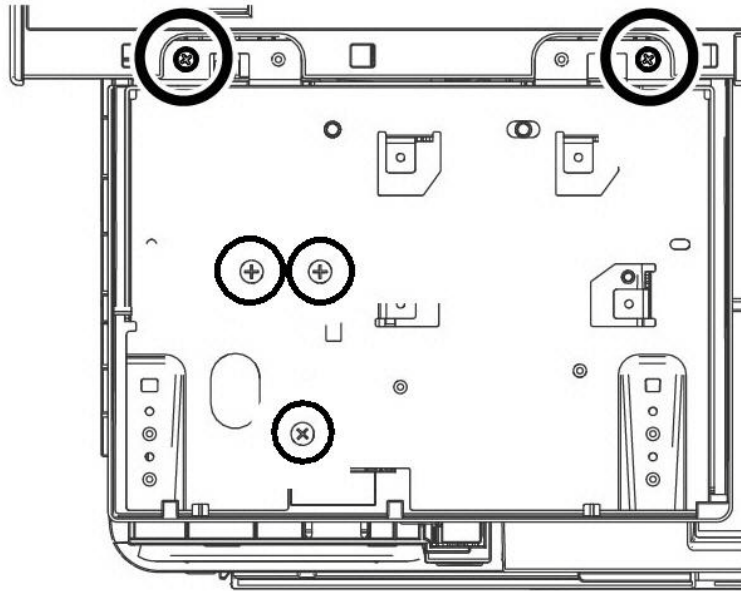
D-8-0014-B

11. Remove the L side finisher cover, PL 19.4 Item 2.
12. Remove the SUB L side finisher cover, PL 19.3 Item 43.
13. Remove the rear finisher cover, PL 19.4 Item 3.
14. Remove the inner rear finisher cover, PL 19.3 Item 31.
15. Remove the IIT front cover, PL 50.1 Item 19.
16. Remove the UI inner cover, PL 1.1 Item 2.
17. Remove the top ESS plate, PL 18.1 Item 18.
18. Refer to Figure 3, remove the 2 screws that connect the UI plate to the scanner, and the three screws in the bottom of the UI plate.

Figure 3 UI plate screw locations

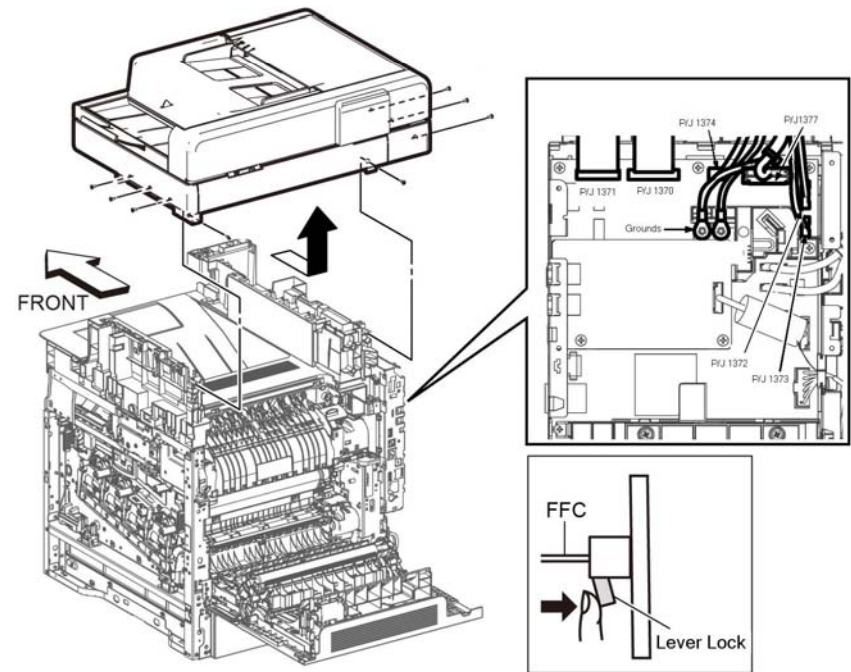
D-8-0198-C

19. Refer to Figure 4, following the caution above, release the 2 FFC cables (P/J1370 and P/J1371) and disconnect (P/J1372, P/J1373, P/J1374, P/J1377) from the ESS PWB.
20. Refer to Figure 4, remove two screws (SM18, silver, M3X6mm) to release the ground harnesses from the ESS PWB, PL 18.1 Item 3.
21. Release three clamps and five push-ties.
22. Refer to Figure 4, remove eight screws (SM18, silver, M3X6mm) to remove the scanner assembly PL 50.1 Item 13 in the direction of the arrow.

Figure 4 Disconnect the harnesses and two FFCs (MFP Std.)

*NOTE: When engaging the release lever on the FFC connector, slightly press open the release lever no more than 15 degrees. Hold the lever while gently removing the FFC from the connector as shown in the inset of Figure 4, Disconnect the harnesses and two FFCs.*

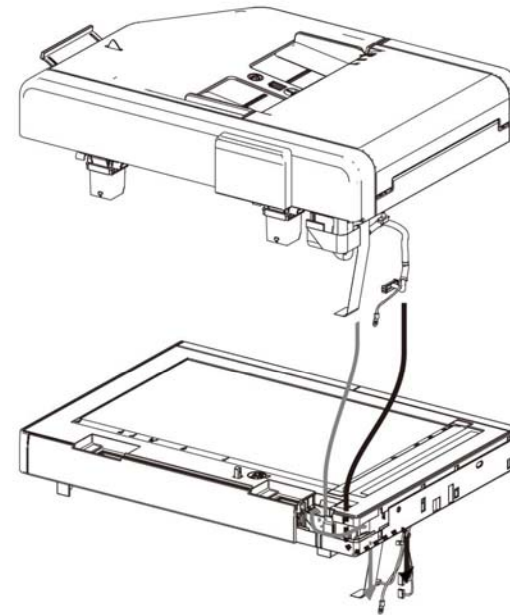
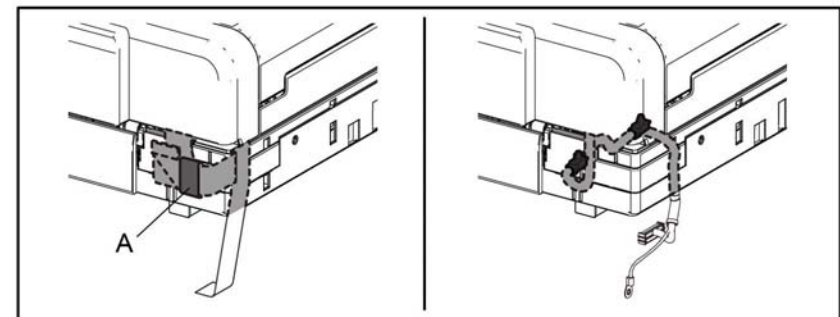
D-8-0201-A

Figure 7 DADF Harness Routes

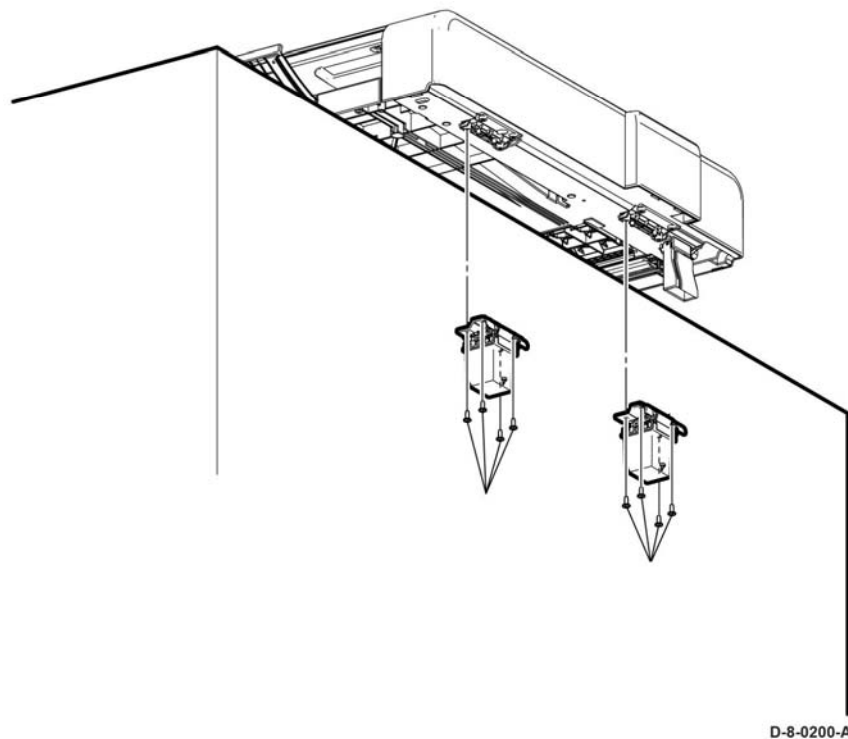
1. Remove the DADF, [PL 50.1 Item 1](#), from the scanner.
2. Refer to [Figure 1](#), rest the DADF on the work surface as shown.
3. Refer to [Figure 1](#), remove eight screws (silver, tapping, m3x8), remove the left and right hinges.

Figure 1 Remove the Hinges

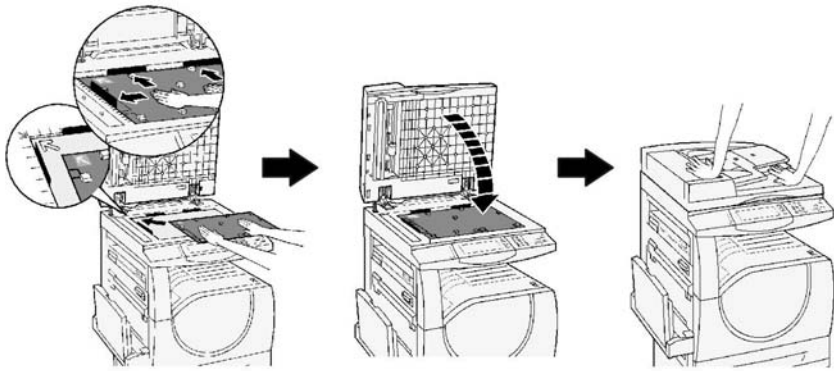
D-8-0374-A

Figure 1 Platen cushion assembly installation method

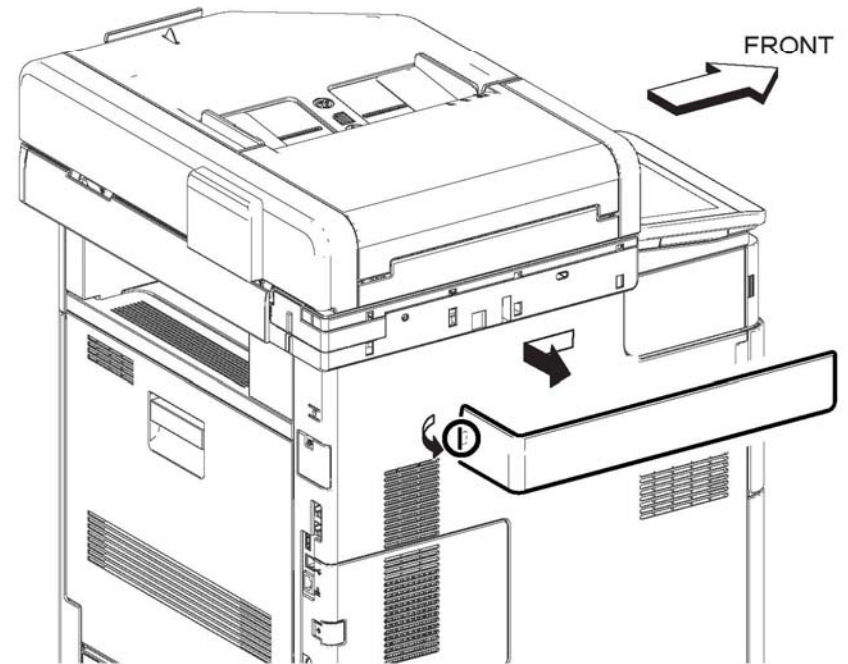
D-8-0009-A

1. Refer to [Figure 1](#) (MFP Std.), [Figure 2](#) (MFP Tall), release the hook on the rear side of the left IIT cover, and remove the left IIT cover.

Figure 1 Left IIT cover removal MFP Std.

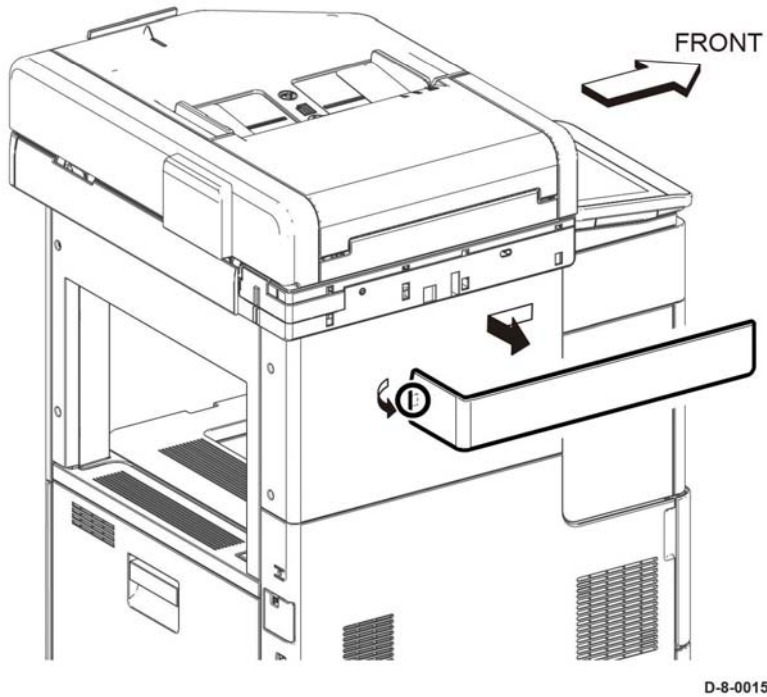
Figure 2 Left IIT cover removal MFP Tall

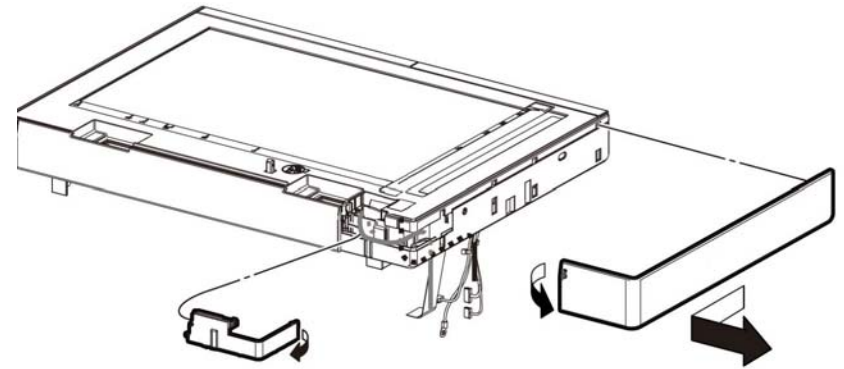
1. Refer to [Figure 1](#), release the hook on the rear side of the left IIT cover, and remove the left IIT cover, [PL 50.1 Item 14](#).
2. Refer to [Figure 1](#), release the hook on the right of the left IIT cap and remove the left IIT cap.

Figure 1 Left IIT cap removal

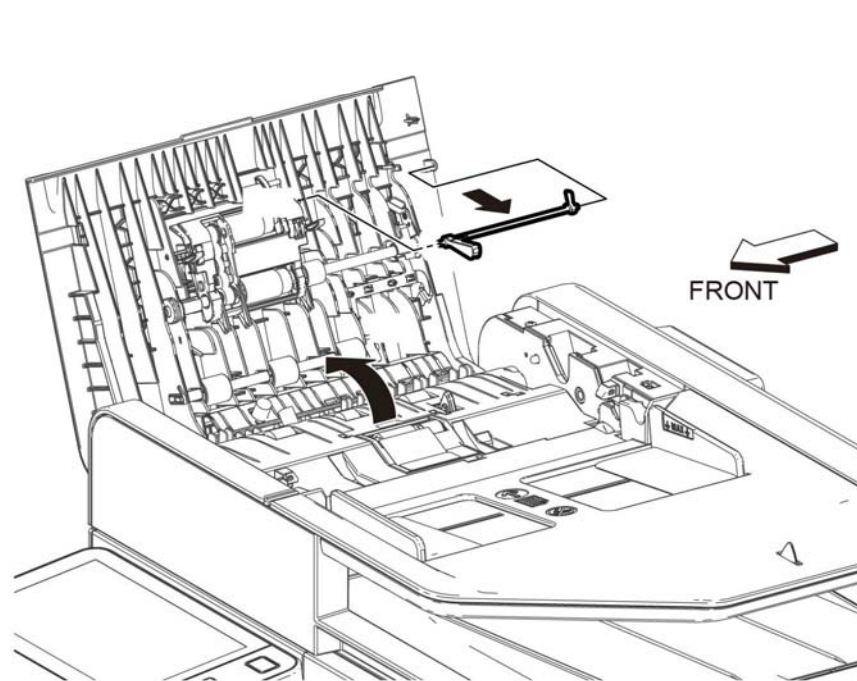
D-8-0211-A

1. Refer to [Figure 1](#), open the DADF Upper Feeder Assembly.
2. Release the two bosses at the ends of the DADF Actuator by slightly bending the Actuator, and remove it.

Figure 1 Remove the DADF Actuator

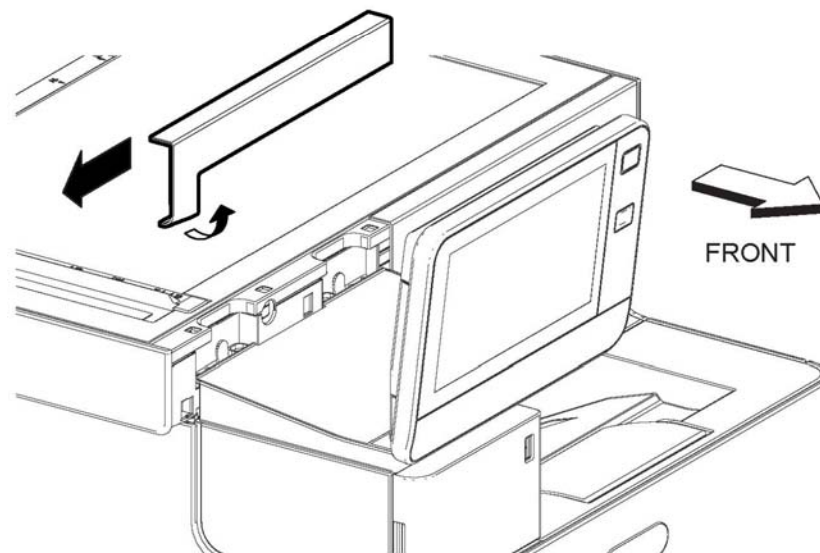
D-8-0010-A

1. Refer to [Figure 1](#), release the hook and remove the front IIT cover.

Figure 1 Remove the Front IIT Cover

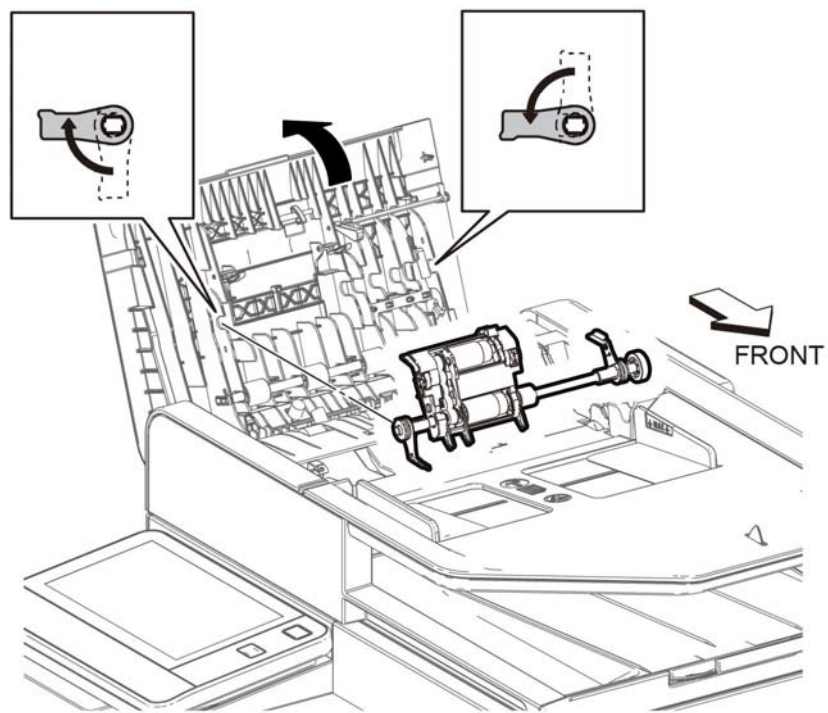
D-8-0202-A

2. Refer to [Figure 1](#), rotate the hook of the DADF Feed Roller and release the boss.
3. Remove the DADF Feed Roller.

Figure 1 Remove the DADF Feed Roller

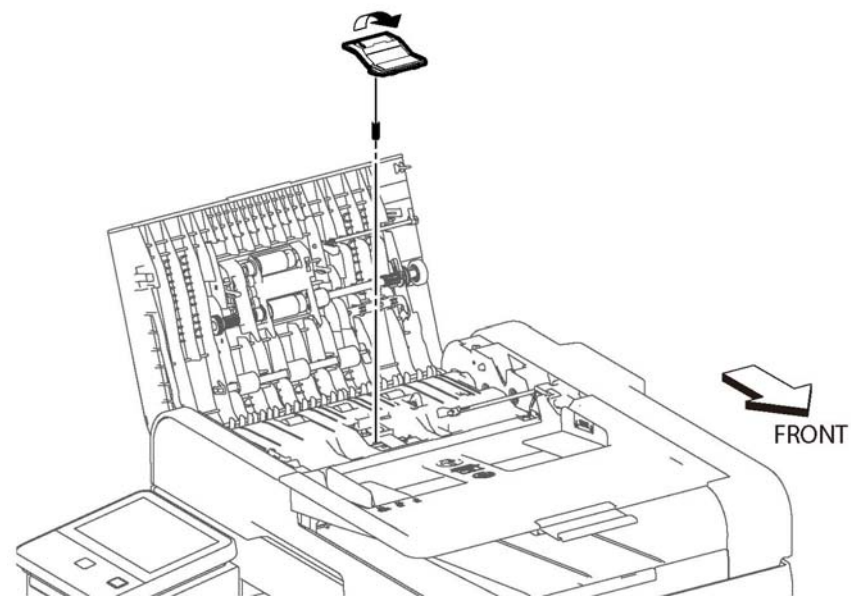
D-8-0211-B

Figure 2 Remove the DADF Separator Cover and Spring

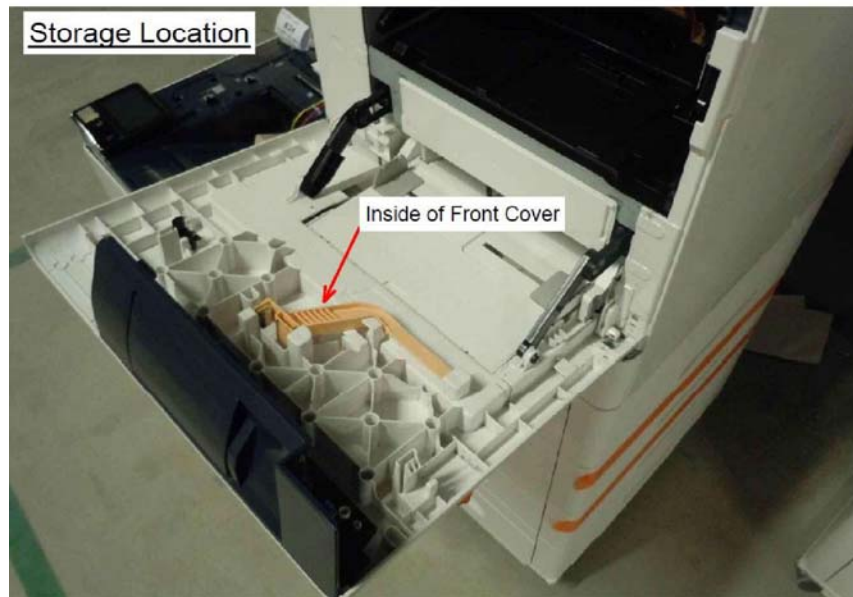
E-8-0762-A

1. Switch off the machine, unplug the cord from the power, GP 4.
2. Open the front door.
3. Remove the cleaning wand from inside the front door, Figure 1.

Figure 1 Cleaning wand location

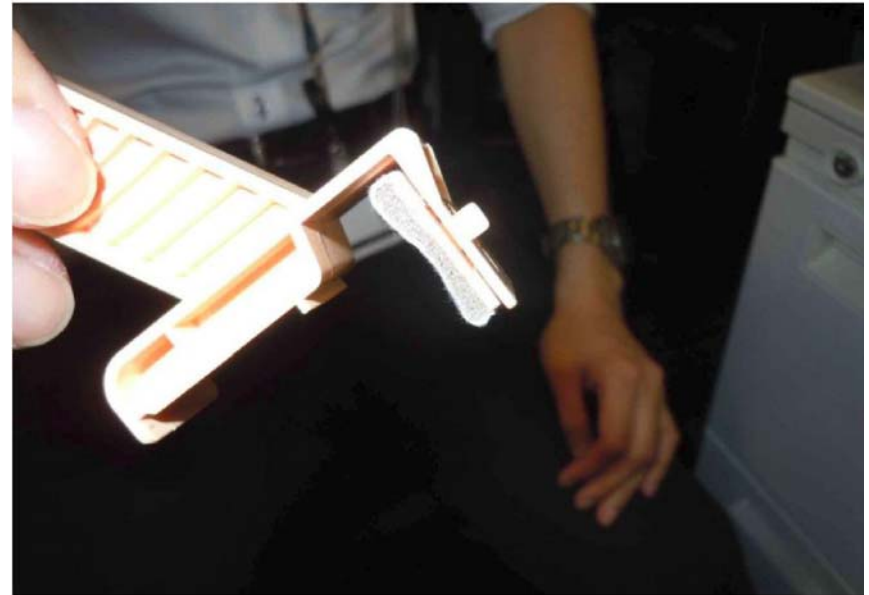
E-8-0763-A

4. Check that the cleaning pad is correctly installed on the cleaning wand. If necessary obtain a clean pad. Figure 2.

Figure 2 Cleaning pad location

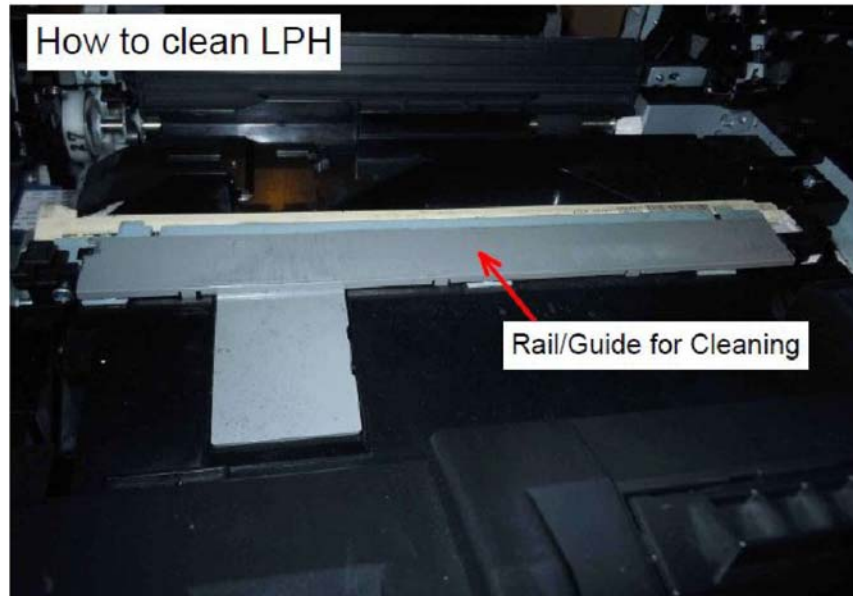
E-8-0764-A

5. Identify the position of the guide rail. [Figure 3](#).

Figure 3 Guide rail location

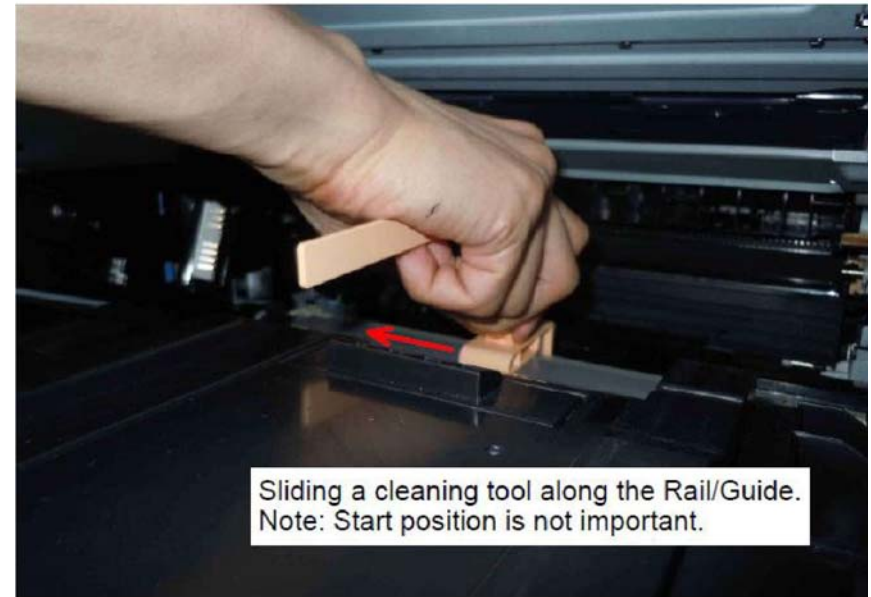
E-8-0765-A

6. Put the cleaning wand over the guide rail so that the flat face of the wand sits on the guide rail as shown in [Figure 4](#).

Figure 4 Cleaning wand positioning

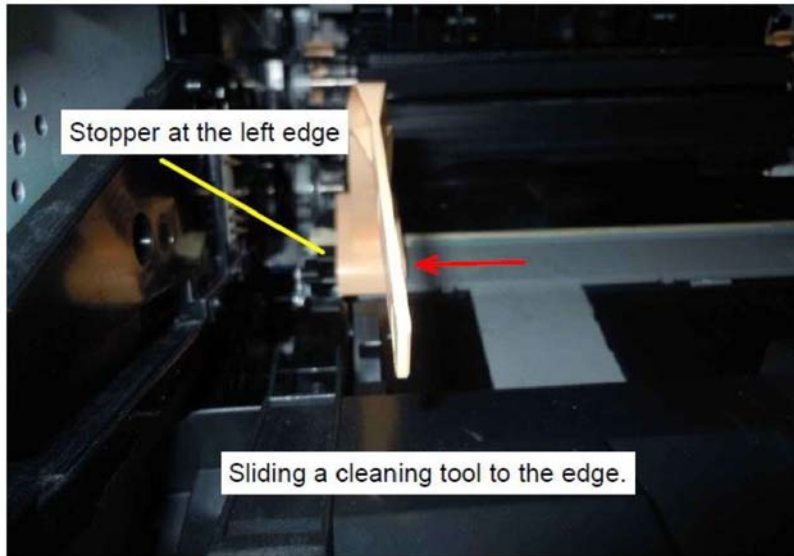
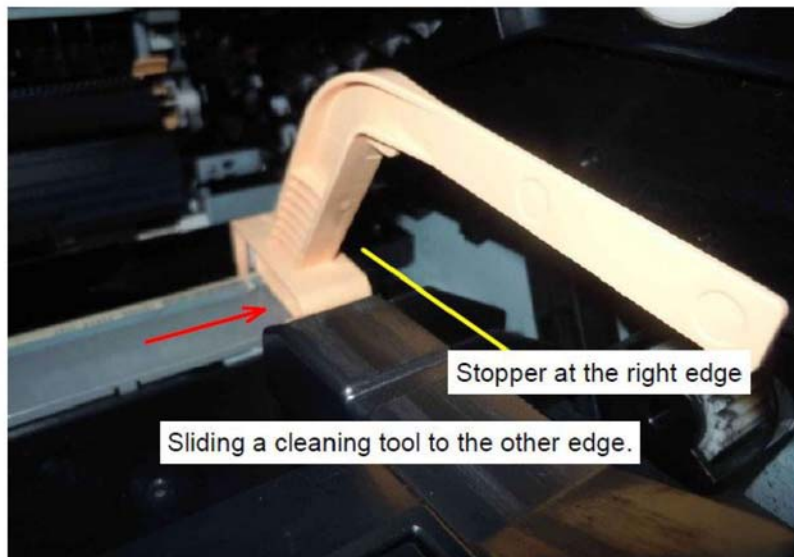
E-8-0766-A

7. Slide the wand along the guide rail until it reaches the stopper on the left edge and the right edge, [Figure 5](#).
8. If the error persists, go to RAP [089-623 to 089-679](#) LED Offset Correction Error RAP.

Figure 5 Cleaning wand movement to clean LPH

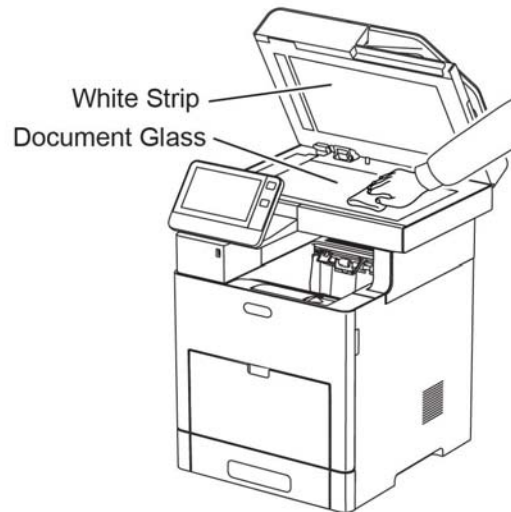
E-8-0075-A

4. Clean the document glass, the side-1 scanning area (to the left of the of the document glass) and the white strip, Figure 1.

Figure 1 Clean the document glass

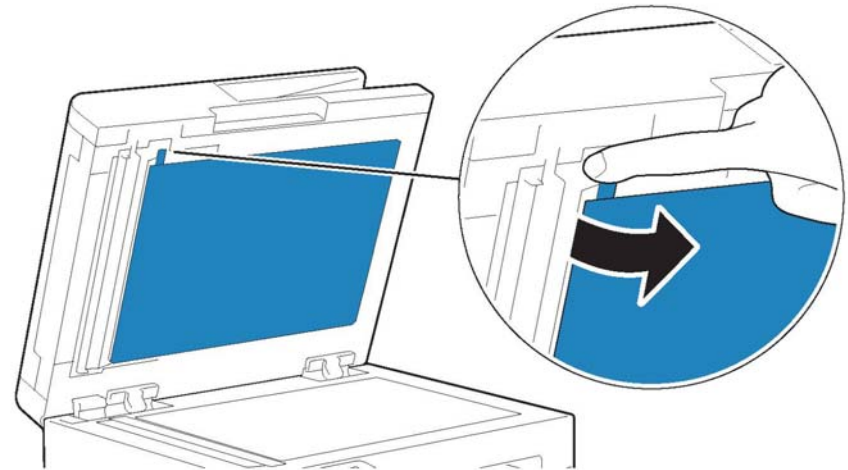
E-8-0076-A

6. To access the second-side scanning lens assembly, lower the second-side scanning access cover Figure 2.

Figure 2 Opening the second-side scanning access cover

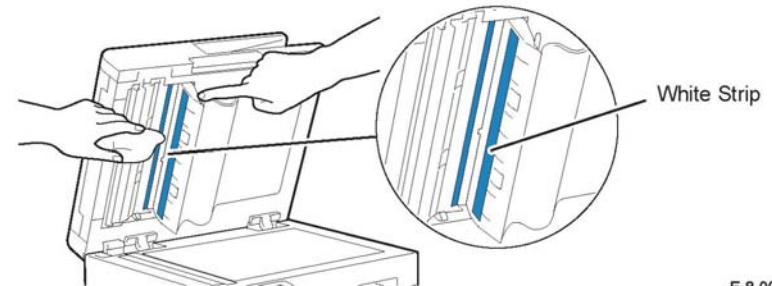
E-8-0077-A

7. Using a soft cloth moistened with water, wipe the mirrored glass, the white-plastic strip, and the rollers, Figure 3. If dirt is difficult to remove, moisten a soft cloth with a small amount of neutral detergent. Then wipe the printer parts dry with a soft cloth.

Figure 3 Clean the second-side scanning lens assembly

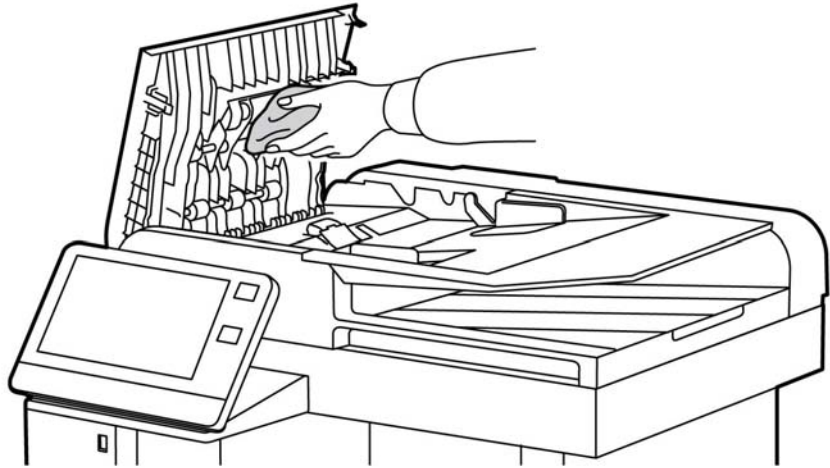
E-8-0767-A

2. Wipe the feed rollers with a dry, soft, lint-free cloth or paper towel until the rollers are clean, [Figure 4](#).

Figure 4 Cleaning the DADF feed rollers

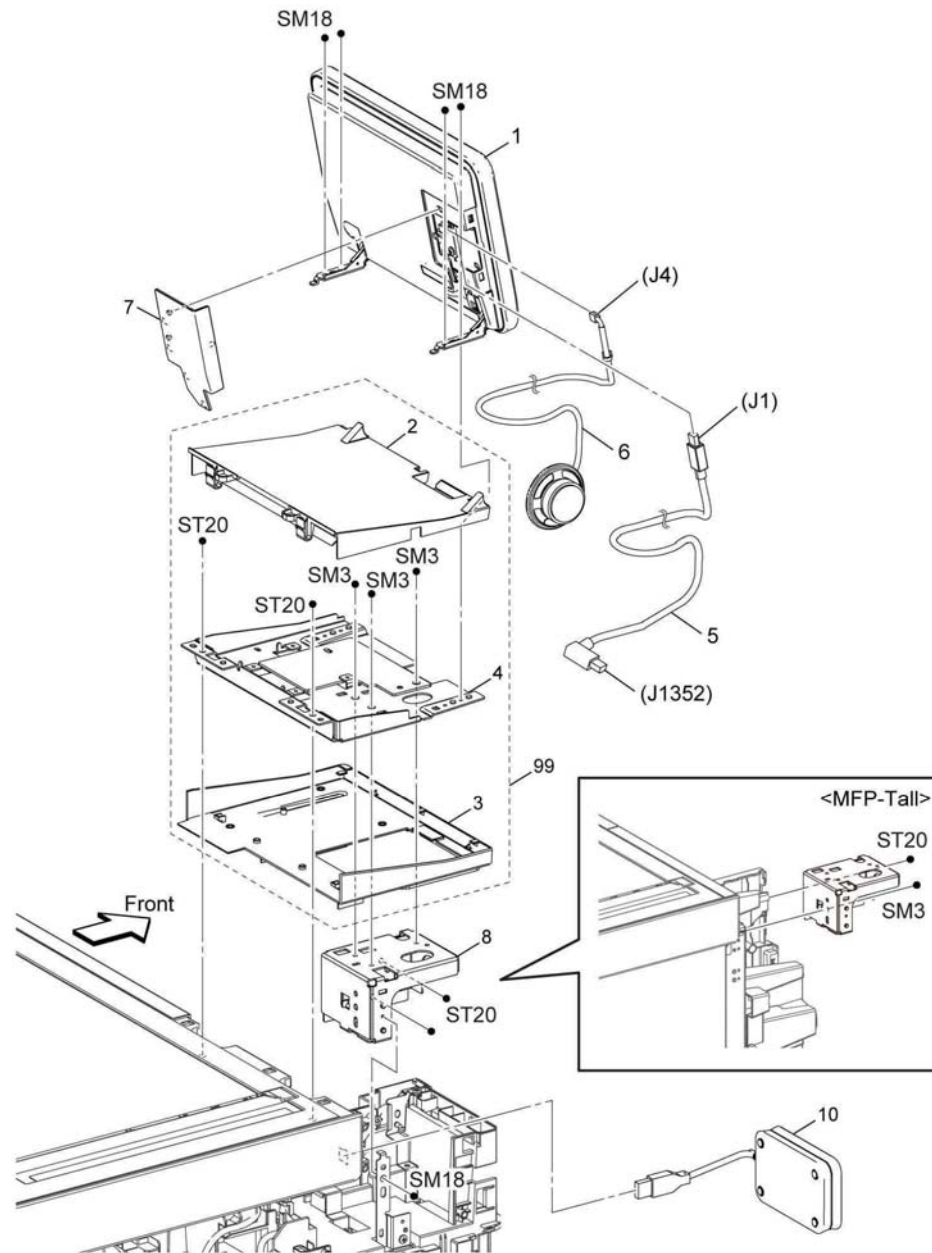
E-8-2001-A

## PL 1.1 UI MFP-Std, B615\_Tall

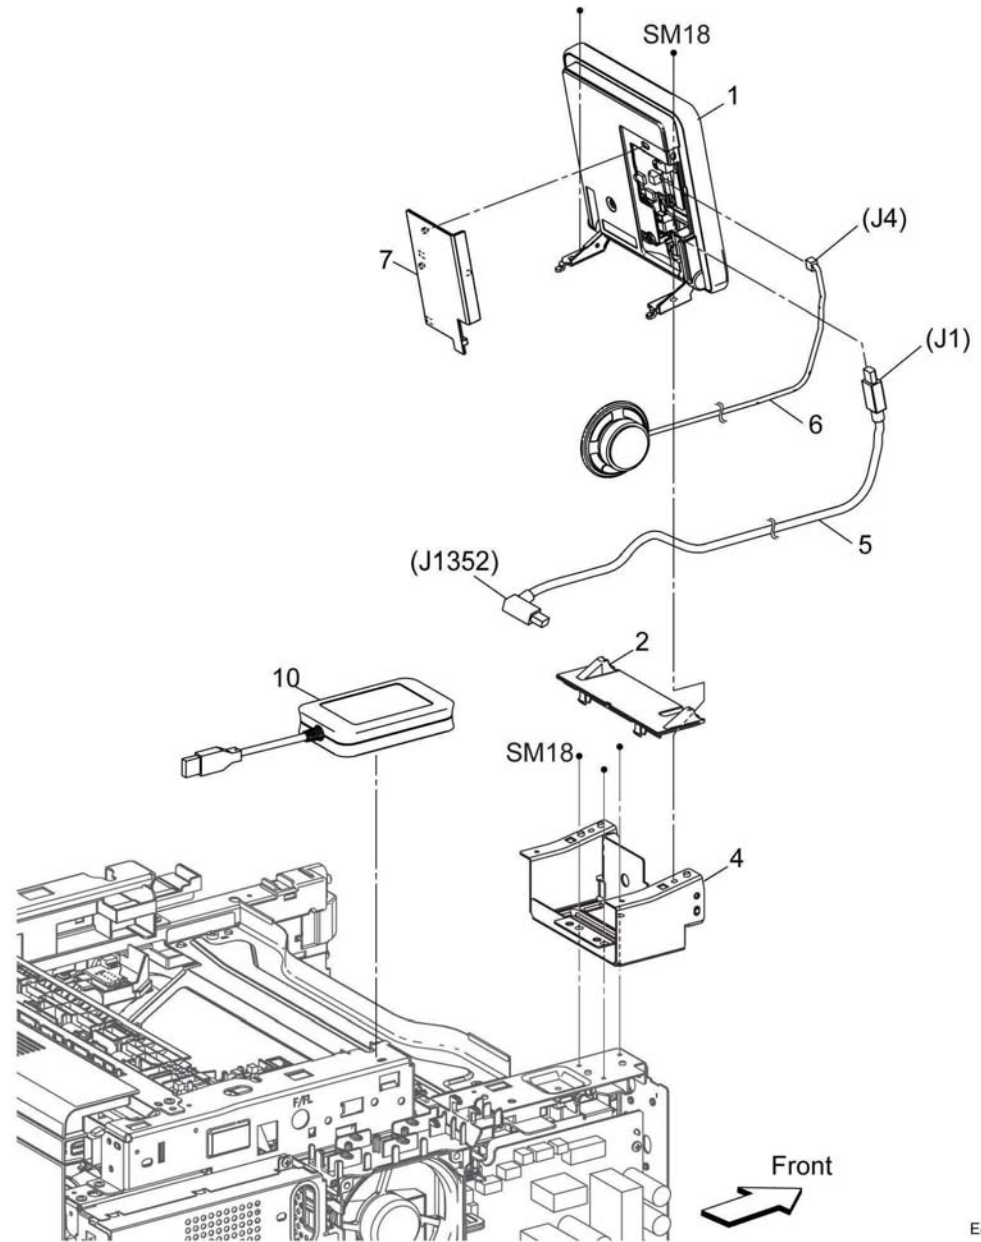
E-8-2002-A

## PL 1.2 UI (B600/B610)

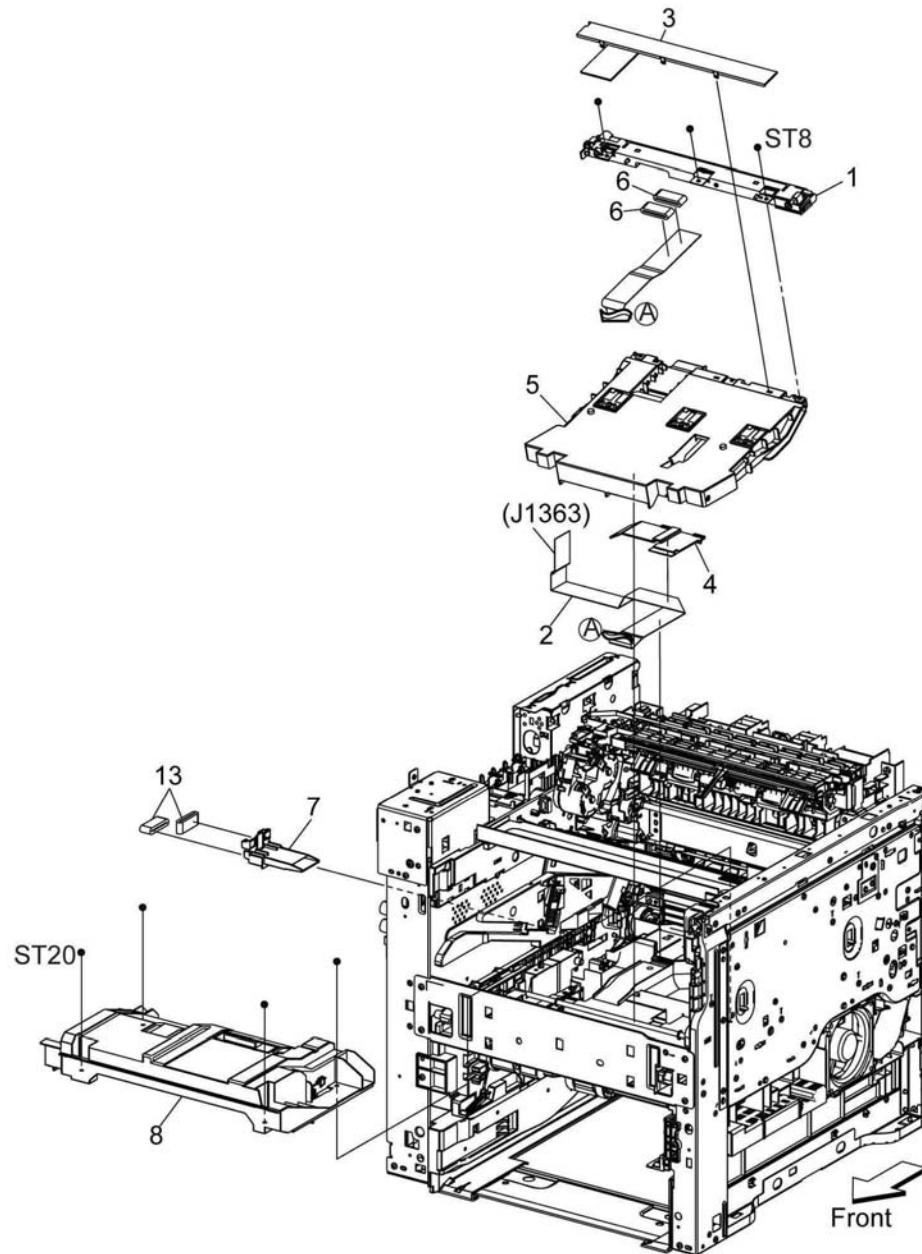
E-8-2003-A

## PL 2.1 LPH

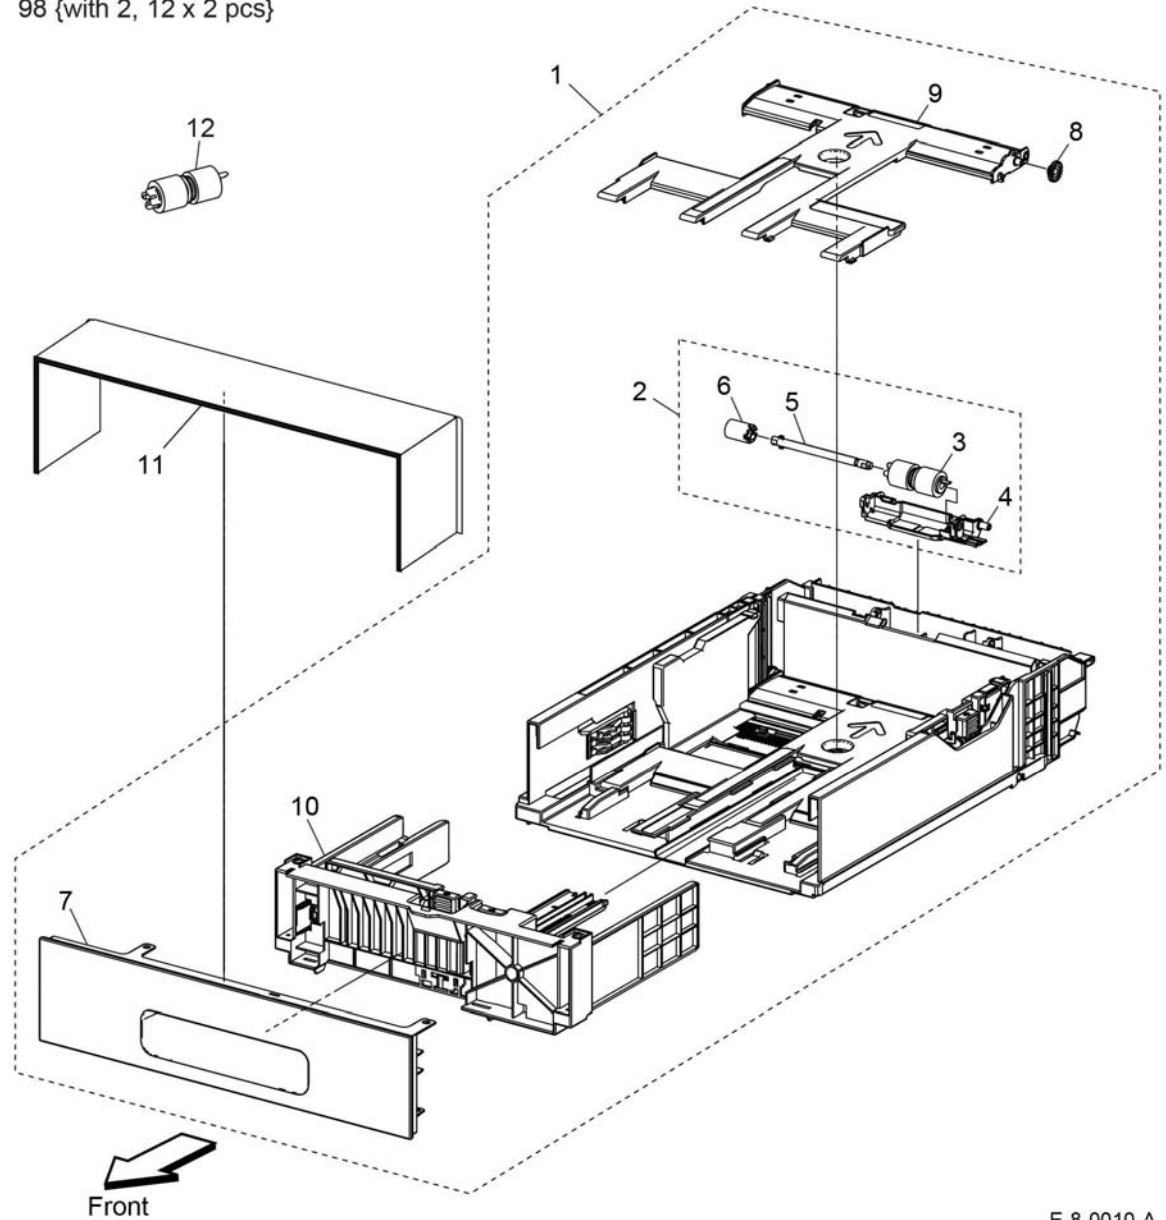
E-8-0010-A

# PL 9.1 Tray

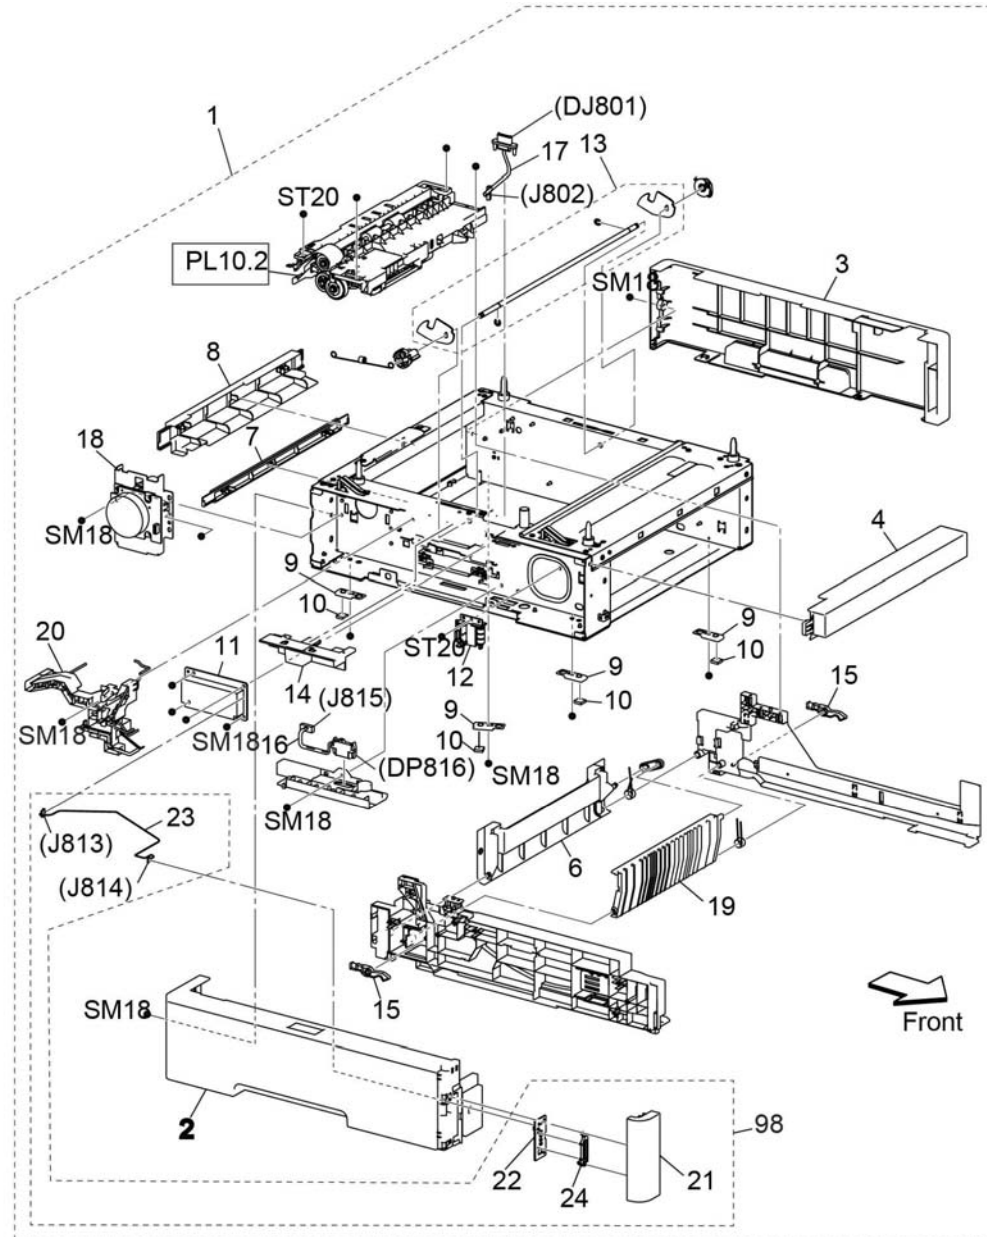
E-8-0011-A

## PL 10.1 Option Feeder (1/3)

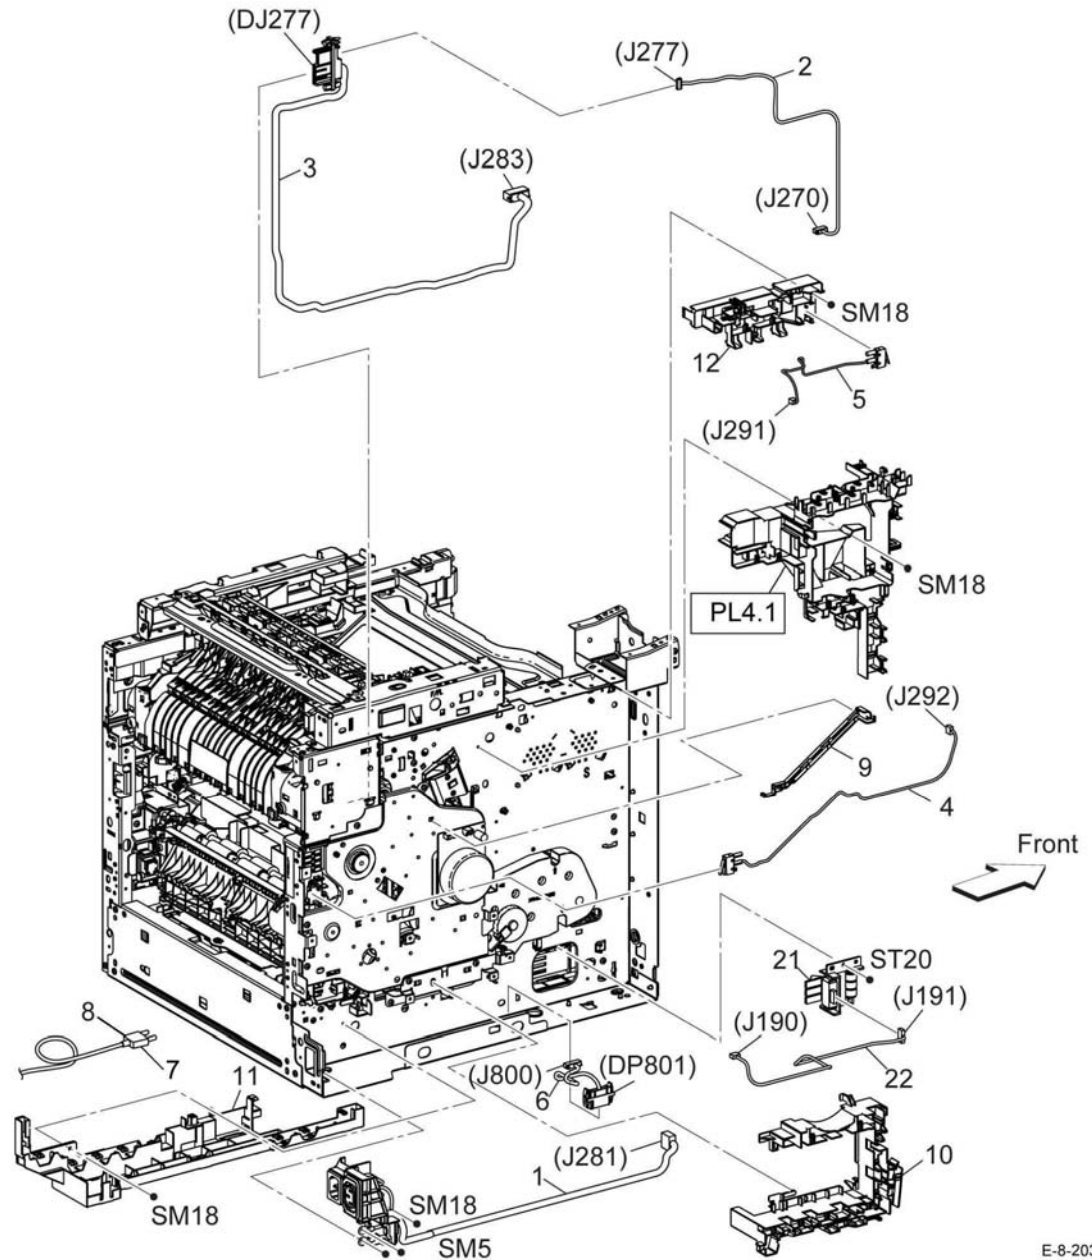
**AVVERTENZA:** Spegnere la macchina. Scollegare il cavo di alimentazione dall'alimentatore quando si eseguono attività che non richiedono elettricità. L'elettricità può causare morte o lesioni personali. Le parti in movimento possono causare lesioni personali.

### WARNING

Switch off the electricity to the machine, **GP 4**. Disconnect the power cord from the customer supply while performing tasks that do not need electricity. Electricity can cause death or injury. Moving parts can cause injury.

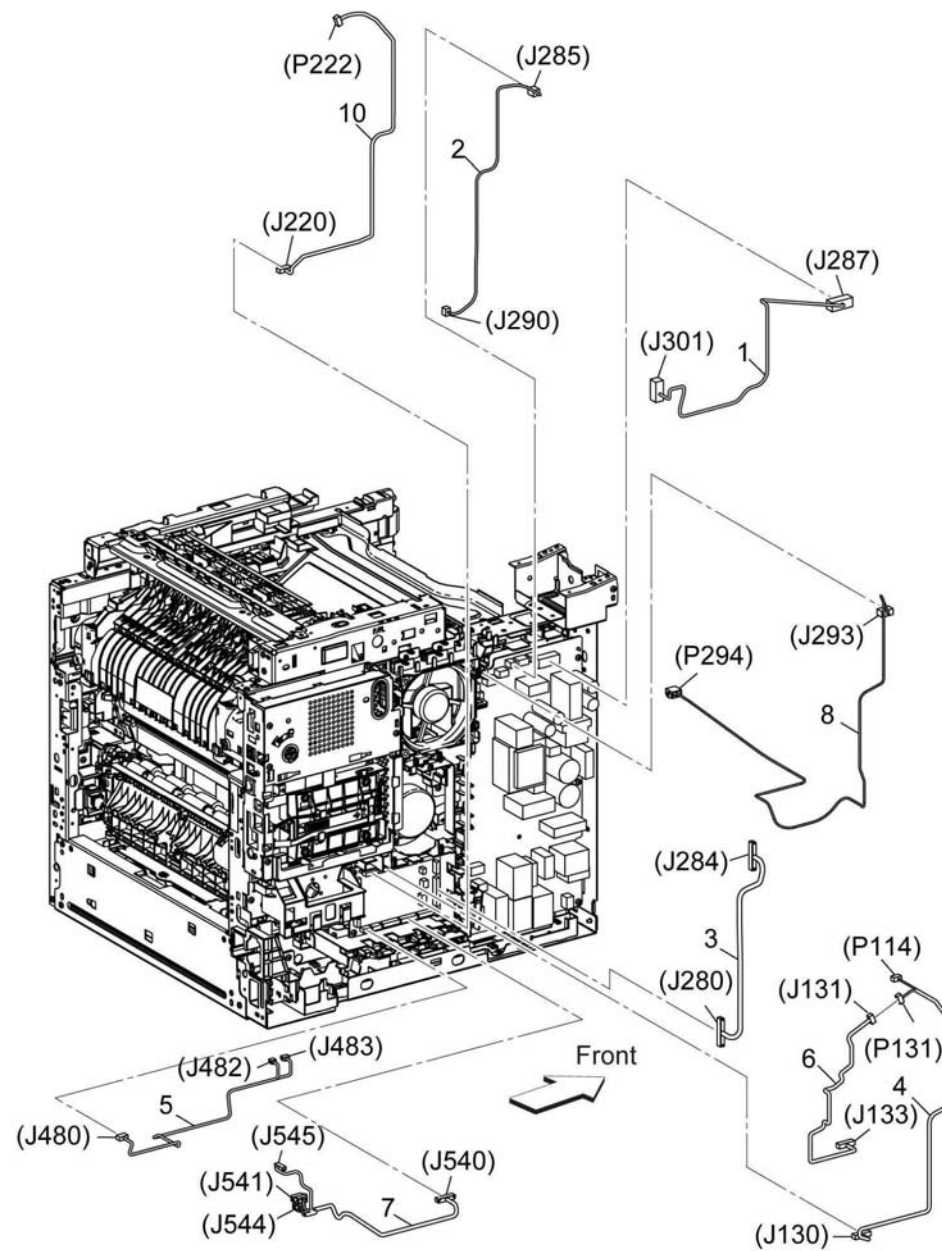
Perform the steps in the following procedure carefully. Failure to follow this procedure carefully could result in electrical shock and personal injury.

**VORSICHT:** Schalten Sie die Stromversorgung der Maschine ab. Ziehen Sie das Stromkabel ab, wenn Sie Aufgaben ausführen, für die keine Stromversorgung benötigt wird. Stromschläge können Todesfällen oder Verletzungen verursachen. Bewegliche Teile können zu Verletzungen führen.

**AVISO:** Apague la electricidad de la máquina. Desconecte el cable de alimentación eléctrica de la toma de pared mientras esté realizando tareas que no necesiten corriente. La electricidad puede causar daños o la muerte. Las partes móviles pueden causar daños.
