# VersaLink® B600/B610 Printer and B605/B615 Multifunction Printer Service Manual

Xerox® VersaLink® B600 Family MFP Service Manual

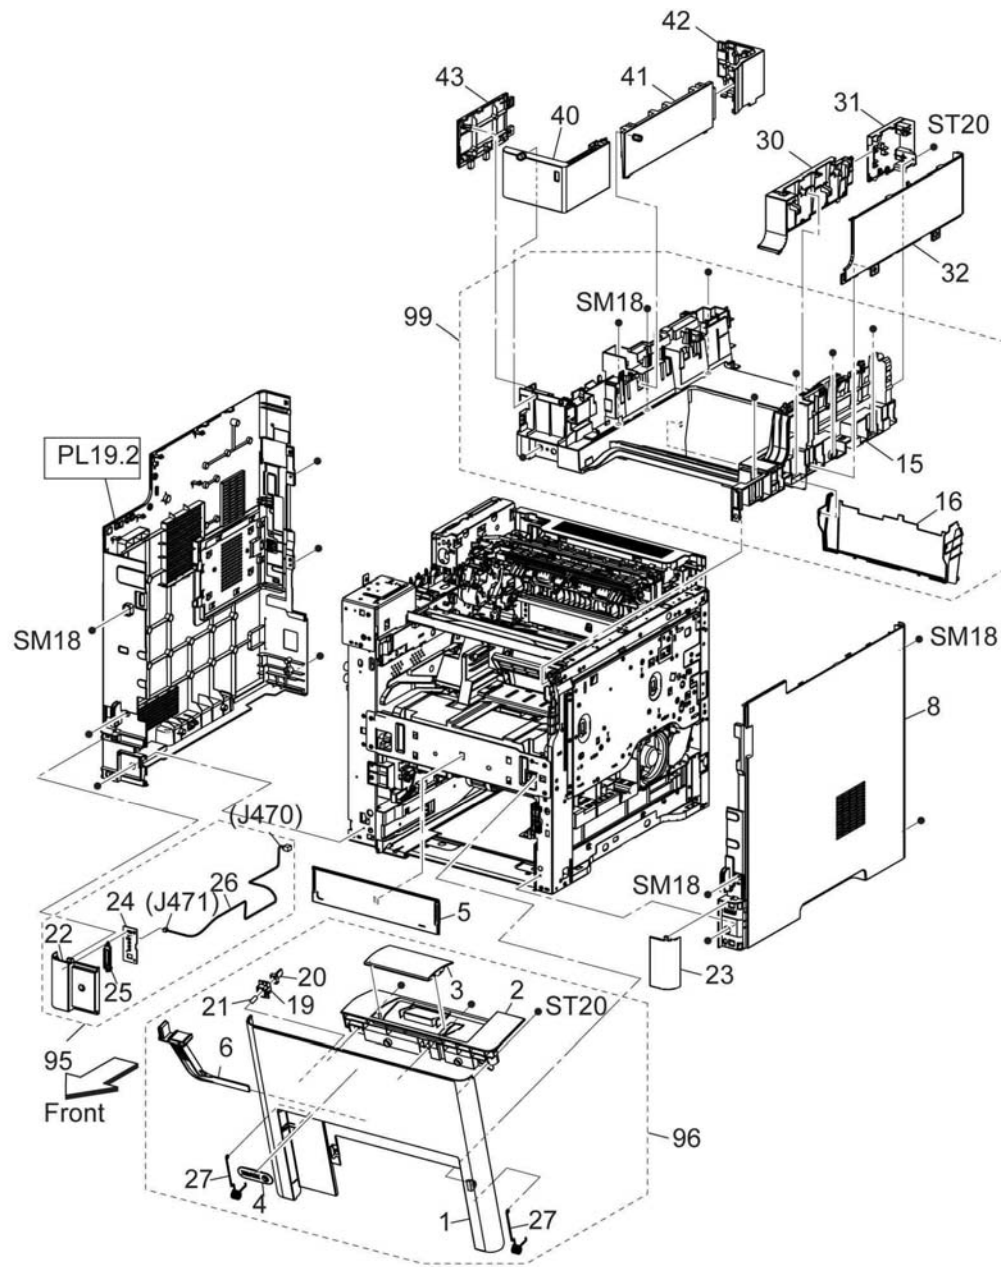
## WARNING

**DANGER:** Faire très attention en effectuant les étapes de la procédure suivante. Si cette procédure n'est pas strictement respectée, il y a des risques d'électrocution et d'autres blessures.

**AVVERTENZA:** Si prega eseguire attentamente la seguente procedura. Omettere di eseguire attentamente la procedura indicata può provocare forti scosse e gravi ferite.

**VORSICHT:** Befolgen Sie die Schritte der folgenden Anleitung genau. Die Nichtbefolgung dieser Anweisungen kann elektrischen Schlag oder andere Körperverletzungen zur Folge haben.

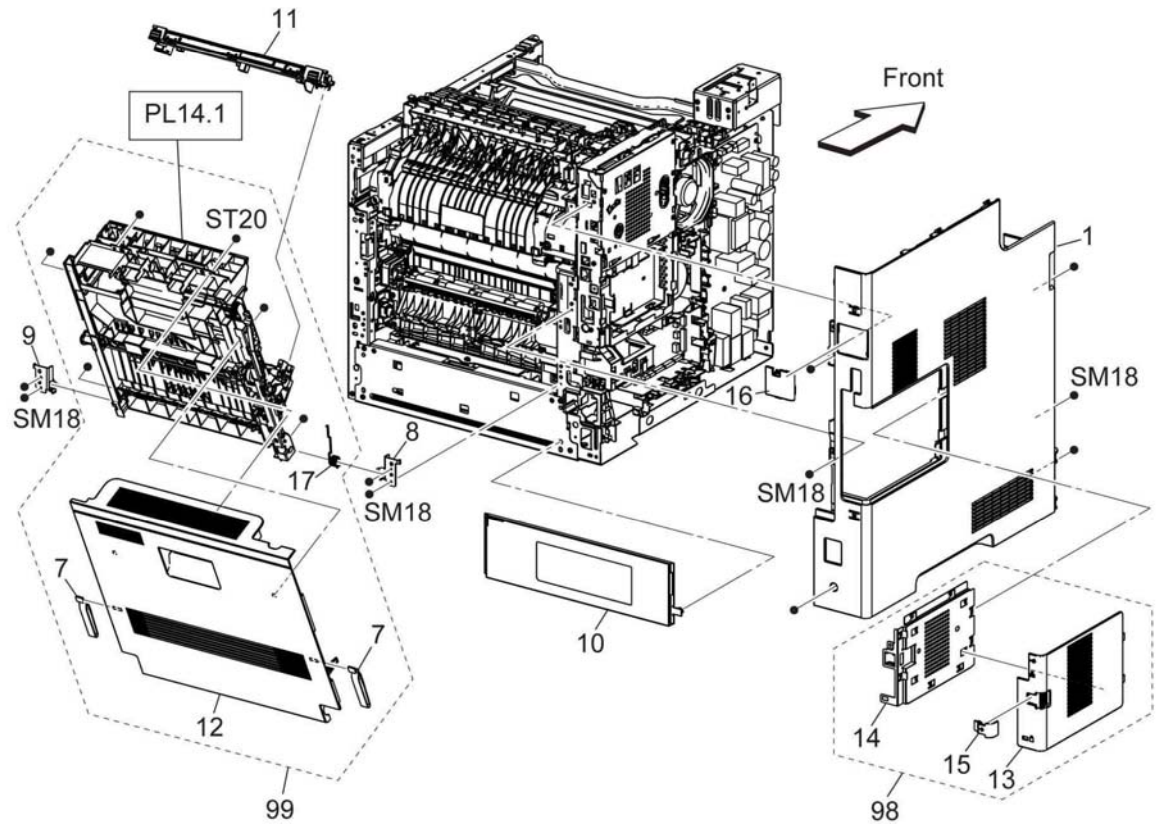
**VORSICHT:** Bei Arbeiten in folgenden Bereichen besondere Vorsicht walten lassen. Einige der Komponenten sind elektrisch aufgeladen und können bei Berührung einen Stromschlag und körperliche Verletzung verursachen

Use extreme care when working in the following area. Some of the components are electrically energized and could cause electrical shock and personal injury if touched.

**DANGER:** Faire très attention en travaillant dans la zone suivante. Certains éléments portent une charge électrique et présentent un risque d'électrocution et de graves blessures s'ils sont touchés.

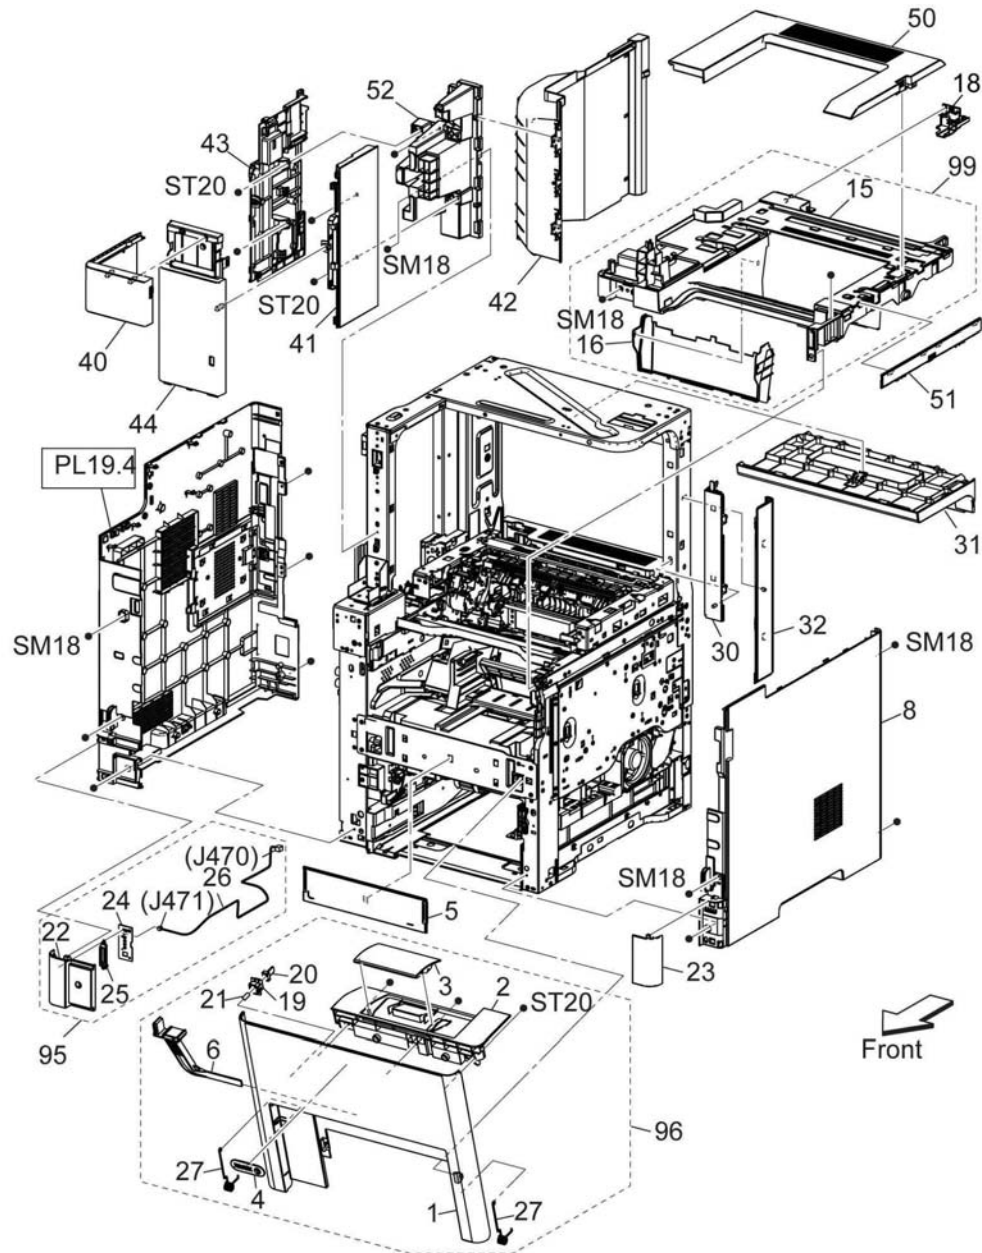
**AVVERTENZA:** Non lavorare in uno spazio limitato; è necessario uno spazio di almeno un metro attorno alla macchina per la sicurezza dell'operatore.

**AVISO:** Tenga mucho cuidado al trabajar en el área siguiente. Algunos de los componentes están cargados eléctricamente y podrían producir descargas y lesiones, si se tocan

## WARNING

Do not work in a confined space. 1 m (39 inches) space is needed for safe working.

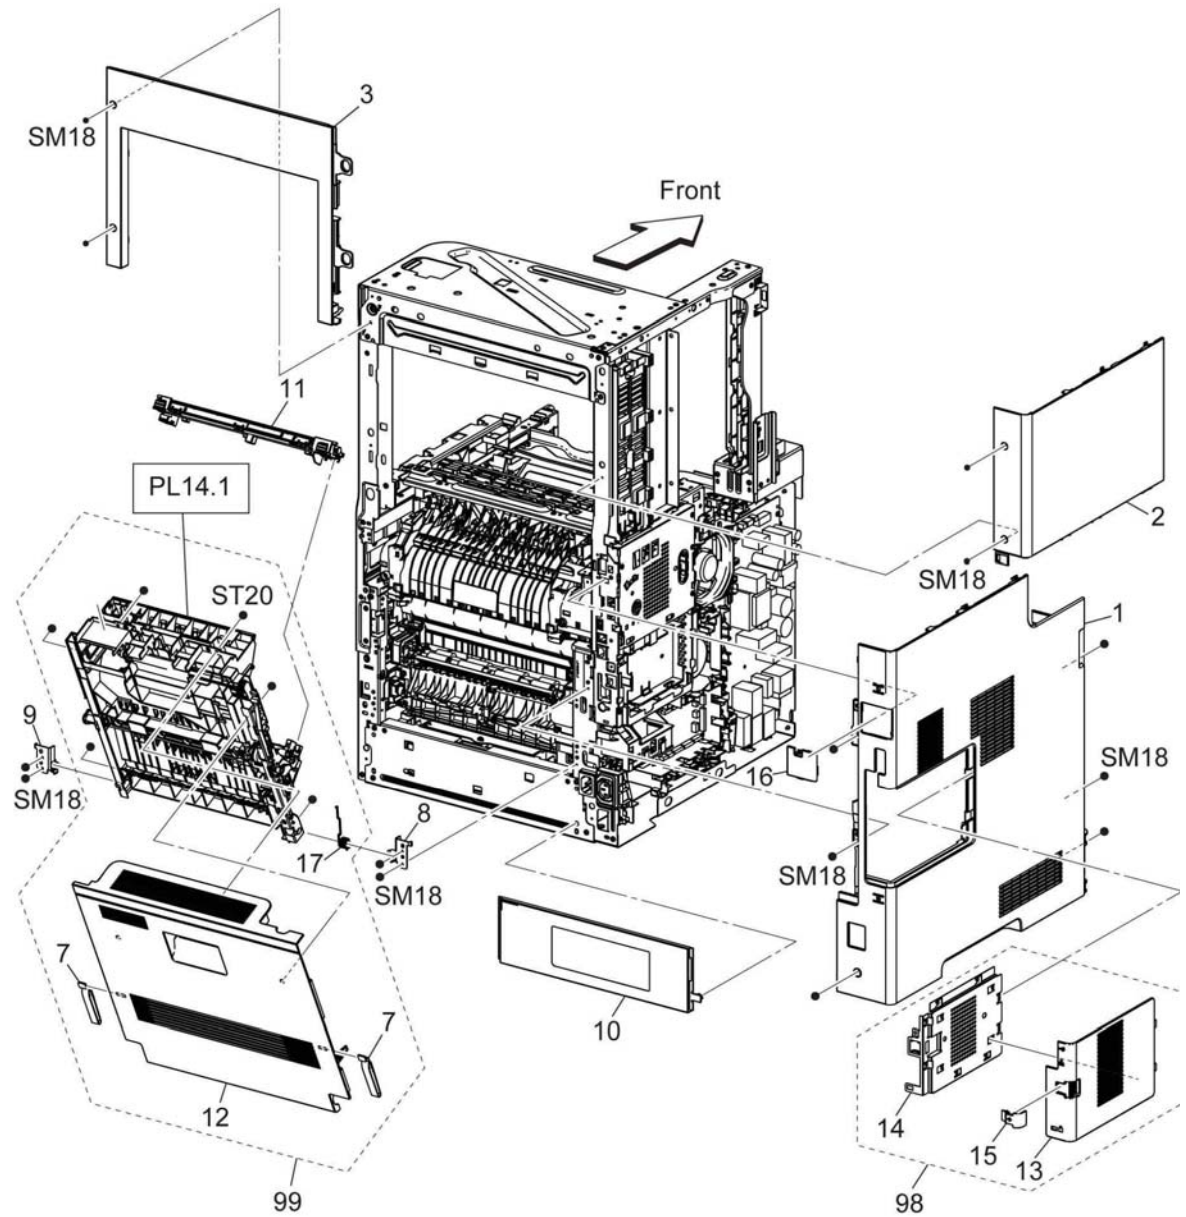
Use safe handling procedures when removing the module. Refer to **GP 4**. The module is heavy.

**VORSICHT:** Nur mit ausreichendem Bewegungsspielraum (1 m) arbeiten.

**AVISO:** No trabaje en un espacio reducido. Se necesita 1 metro de espacio para trabajar con seguridad.

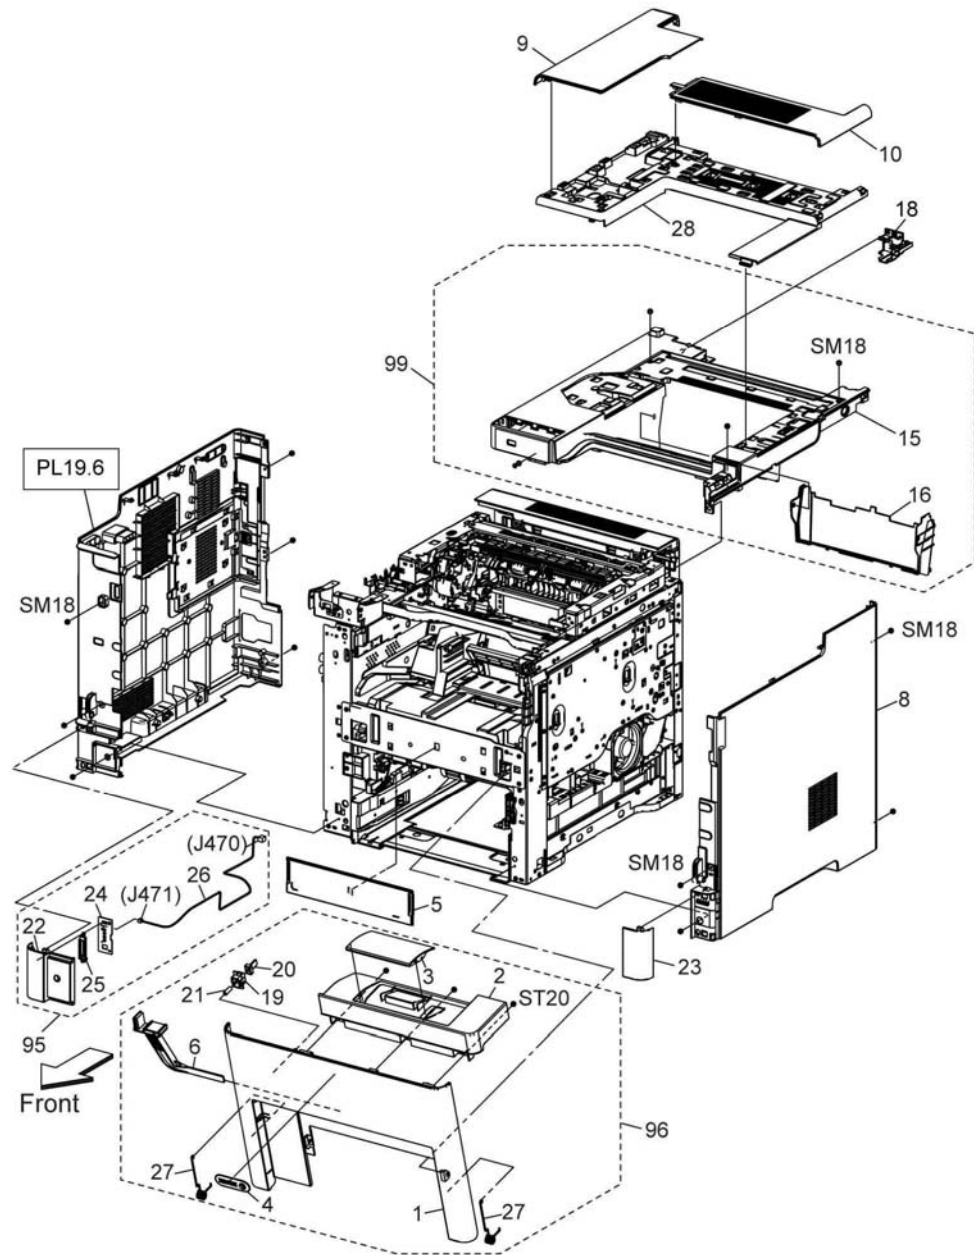
## PL 19.5 Cover (B600/B610) (1/2)

Item	Part	Description
1	-	Cover front (not spared)
2	-	Cover front top (not spared)
3	-	Tray extension (not spared)
4	-	Logo (not spared)
5	-	Cover front IN
6	-	Not used
7	-	Not used
8	822E32401	Cover side R <a href="#">REP 19.15</a>
9	-	Cover top rear L (not spared)
10	822E32383	Cover top rear R
11	-	Not used
12	-	Not used
13	-	Not used
14	-	Not used
15	-	Cover top (not spared)
16	-	Cover exit (not spared)
17	-	Not used
18	-	OPT blind cover (not spared)
19	-	Holder IL (not spared)
20	-	Actuator IL (not spared)
21	-	Spring IL (not spared)
22	-	Cover front L (not spared)
23	822E32421	Cover front R
24	-	Tray LED HVPS PWB (not spared)
25	-	Cover shade tray (not spared)
26	-	Harness assembly LED (not spared)
27	-	Spring cover front
28	-	Cover top exit
95	948K16200	Cover assembly front L (with 22, 24-26)
96	948K16180	Cover assembly front (with 1-4, 6, 19-21, 27)
97	-	Not used
98	-	Not used
99	948K04170	Cover assembly top SFP (with 15, 16) <a href="#">REP 19.20</a>

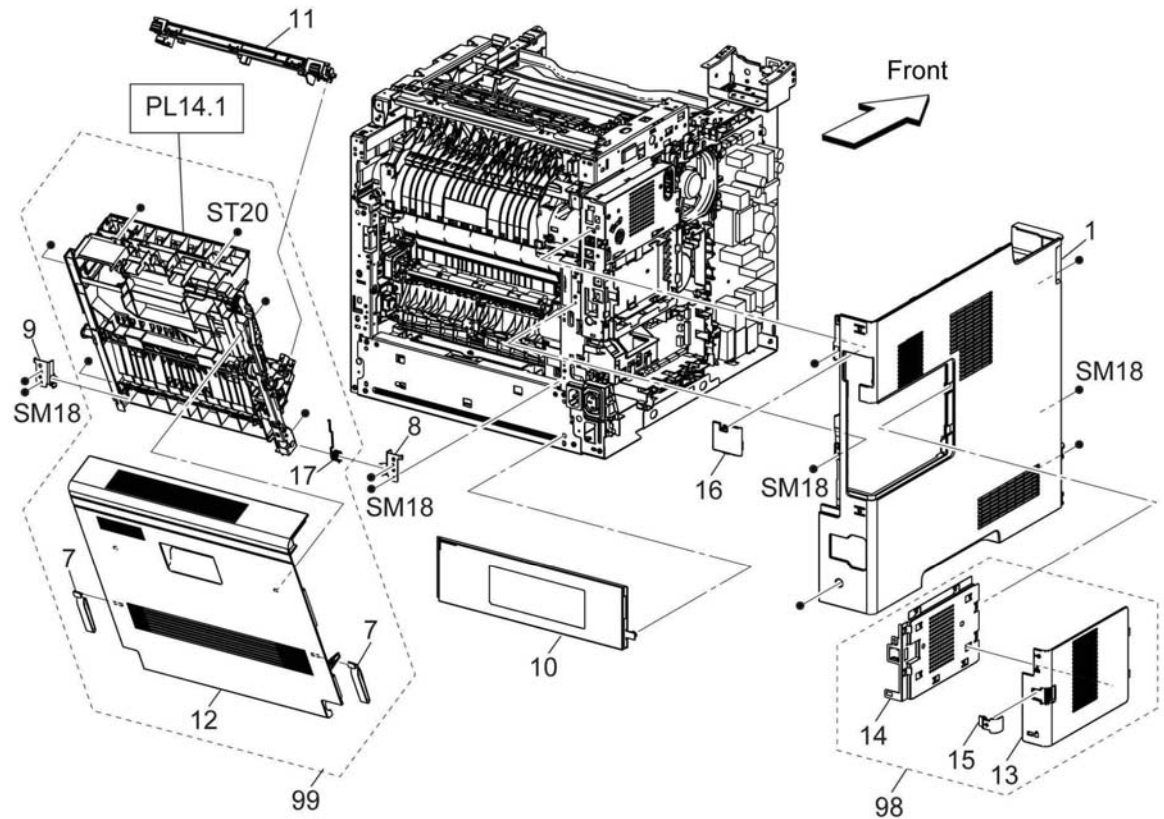
## PL 19.6 Cover (B600/B610) (2/2)

Item	Part	Description
1	-	Cover side L (not spared)
2	-	Not used
3	-	Not used
4	-	Not used
5	-	Not used
6	-	Not used
7	-	Strap cover rear (not spared)
8	-	Hinge assembly rear L (not spared)
9	-	Hinge assembly right R (not spared)
10	-	Cover rear bottom (not spared)
11	-	2nd BTR roll assembly <a href="#">REP 19.22</a>
12	-	Cover assembly rear SFP (not spared)
13	-	ESS window (not spared)
14	-	Plate ESS window (not spared)
15	-	Lever ESS window (not spared)
16	822E27572	WiFi cap <a href="#">REP 19.24</a>
17	-	Spring cover rear (not spared)
98	815K21540	Kit ESS window assembly (with 13-15)
99	-	Kit cover assembly rear SFP (with 7x2, 12, PL14.1) (not spared) <a href="#">REP 19.25</a>

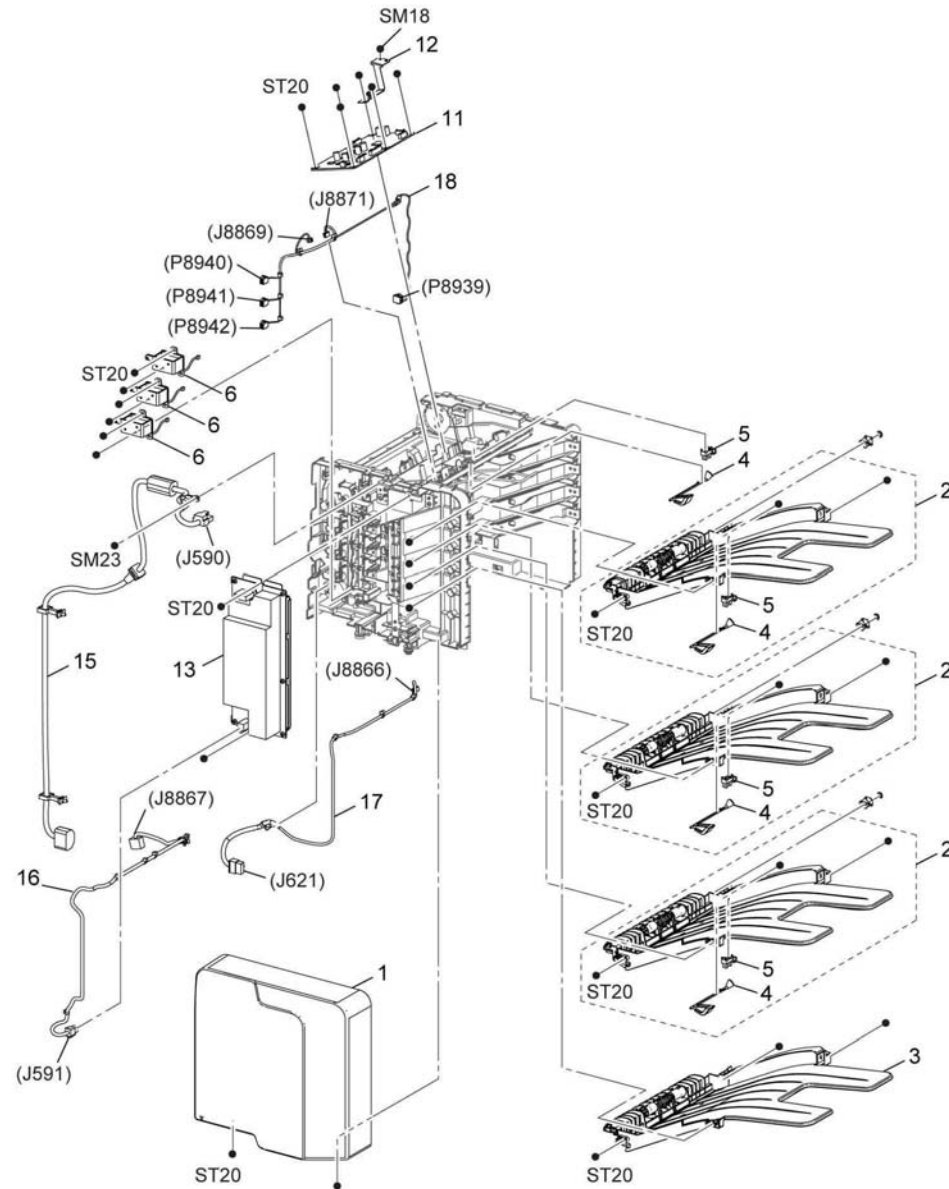
# PL 20.1 Mailbox

Item	Part	Description
1	-	Cover LH C
2	607K05020	Tray assembly (with label) (with 4, 5)
3	607K05030	Tray assembly bottom (with label)
4	-	Actuator tray full
5	-	Sensor photo int (1/2/3/4-bin full paper sensor)
6	049K34930	Bracket assembly gate solenoid
7	-	Not used
8	-	Not used
9	-	Not used
10	-	Not used
11	960K90041	GPF A4MBX PWB
12	960K90043	Bracket earth RH
13	105E22590	LVPS W/I bracket
14	-	Not used
15	-	Harness assembly MBX AC
16	-	Harness assembly MBX DC
17	-	Harness assembly MBX IF
18	-	Harness assembly trans S

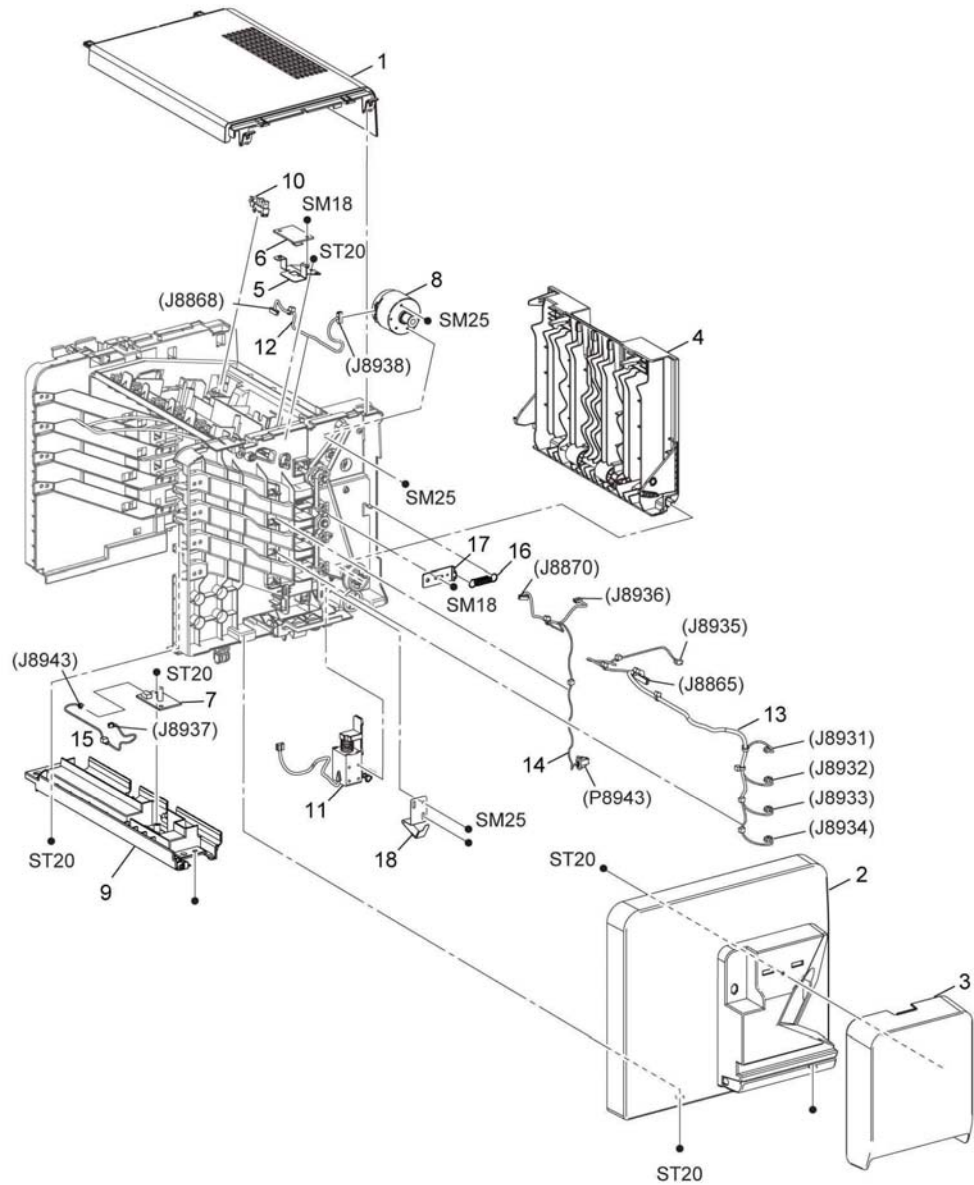
# PL 20.2 Mailbox

Item	Part	Description
1	-	Cover Top C (Not Spared) (REP 20.3)
2	-	Cover RH C (Not Spared) (REP 20.2)
3	-	Cover assembly staple (Not Spared)
4	-	Cover assembly rear (Not Spared)
5	-	Bracket vertical sensor MBX (Not Spared)
6	-	Vertical sensor rev PWB (Not Spared)
7	-	Vertical sensor LED PWB (Not Spared)
8	127K72241	Motor assembly (REP 20.6)
9	-	Chute low MBX (Not Spared)
10	-	Rear cover interlock sensor (Not Spared)
11	121K58300	Solenoid assembly gate (REP 20.7)
12	-	Harness assembly MBX trans M (Not Spared)
13	-	Harness assembly MBX sensor (Not Spared)
14	-	Harness assembly vertical sensor (Not Spared)
15	-	Harness assembly vertical LED (Not Spared)
16	-	Spring tension (Not Spared)
17	-	Bracket tension (Not Spared)
18	-	Plate ground RH (Not Spared)

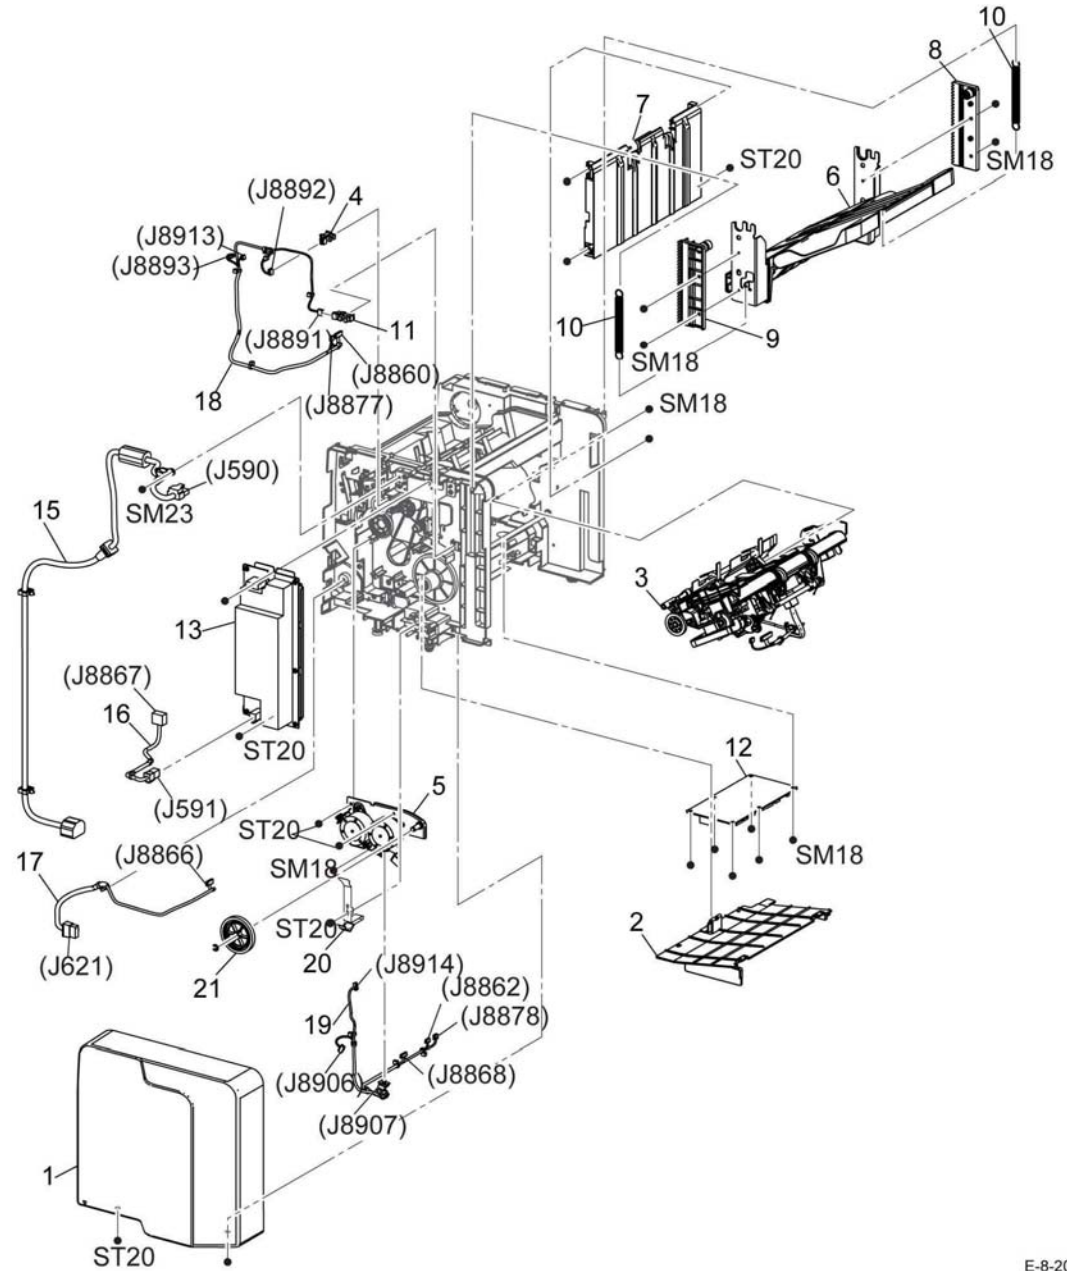
# PL 21.1 Finisher

Item	Part	Description
1	-	Cover LH C
2	-	Cover Lower C
3	-	Tray assembly compile
4	-	Sensor photo int (sub paddle home sensor)
5	049K34570	Motor assembly stepping
6	050K75450	Tray assembly base
7	-	Tray guide C
8	-	Gear assembly Rack R
9	-	Gear assembly rack L
10	-	Spring-lift
11	-	Sensor photo int (stacker tray no-paper & full sensor)
12	960K90034	GPF A4fin PWB
13	105E22590	LVPS
14	-	Not Used
15	-	Harness assembly AC
16	-	Harness assembly fin DC
17	-	Harness assembly fin IF
18	-	Harness assembly fin SNR1
19	-	Harness assembly fin mot
20	-	Plate ground LH
21	-	Gear-Z50 Z20

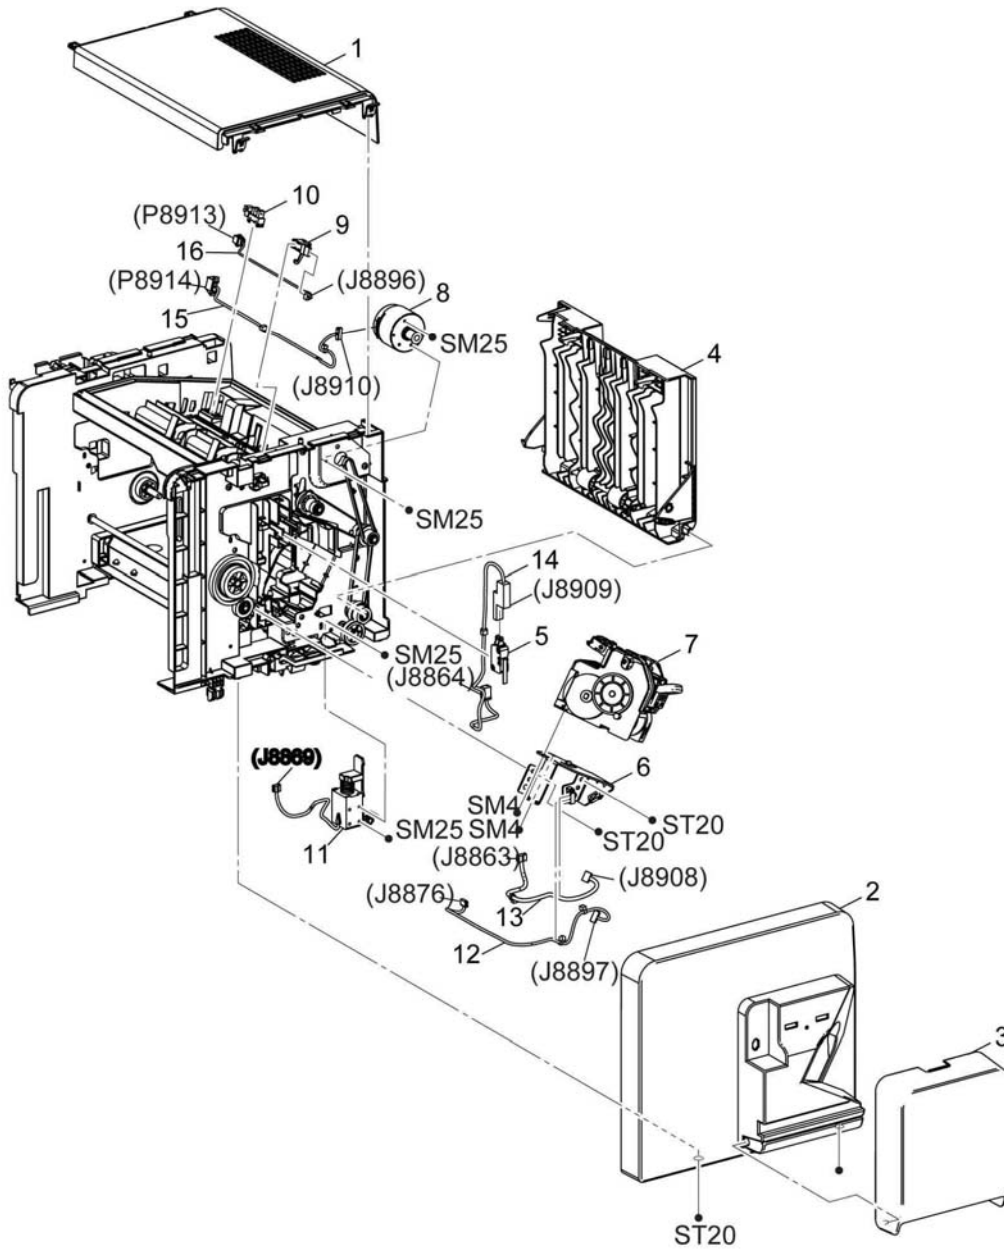
## PL 21.2 Finisher

Item	Part	Description
1	-	Cover top C (Not Spared) (REP 21.3)
2	-	Cover RH C (Not Spared)
3	948K04650	Cover assembly staple
4	-	Cover assembly rear (Not Spared)
5	-	Switch safety IL (Not Spared)
6	-	Bracket stapler (Not Spared)
7	029K93260	Stapler assembly (REP 21.10)
8	127K72241	Motor assembly (REP 21.6)
9	-	Compile exit sensor (Not Spared)
10	-	Rear cover interlock sensor (Not Spared)
11	121K58300	Solenoid assembly gate (REP 21.7)
12	-	Harness assembly staple unit (Not Spared)
13	-	Harness assembly stapler M (Not Spared)
14	-	Harness assembly fin IL (Not Spared)
15	-	Harness assembly fin trans M1 (Not Spared)
16	-	Harness assembly fin compile sensor (Not Spared)
99	006K35670	Shaft assembly - paddle sub

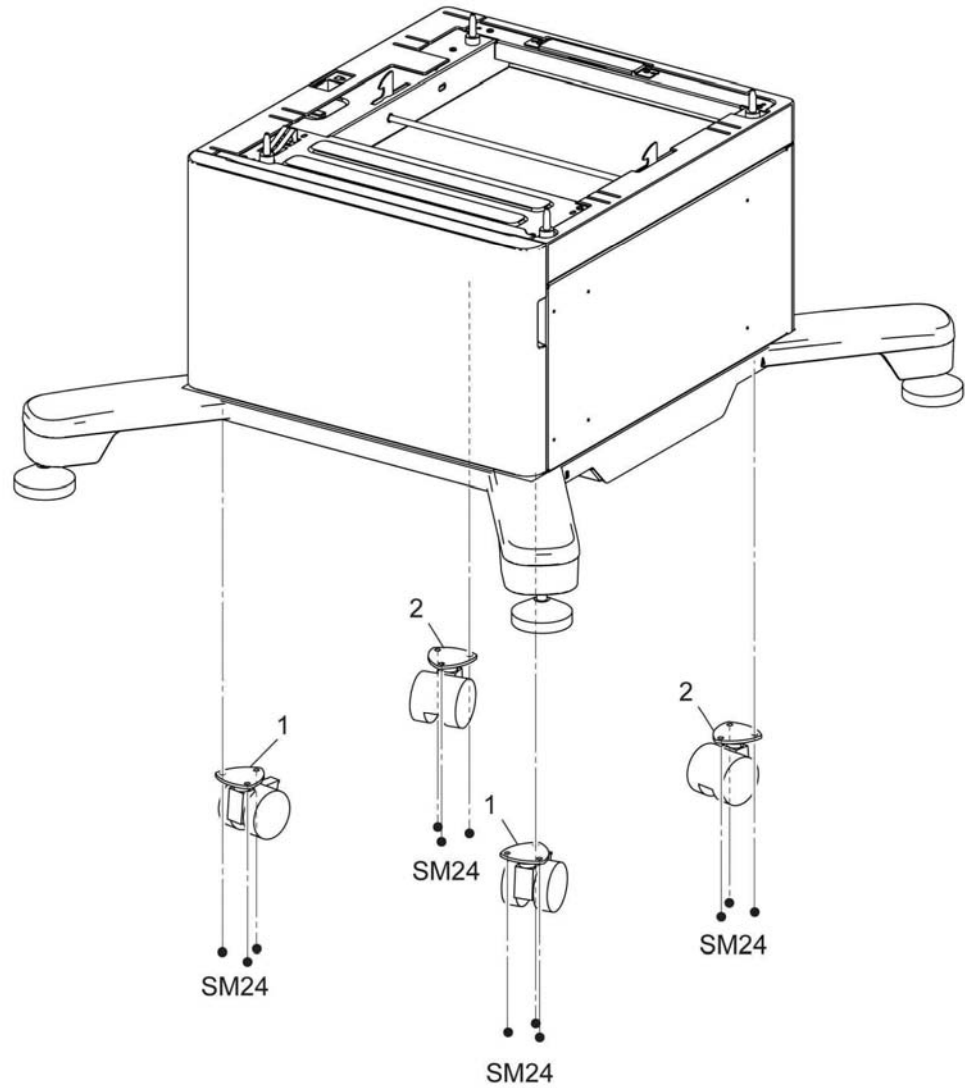
## PL 30.1 Cabinet

Item	Part	Description
1	-	Caster (with lock)
2	-	Caster (without lock)

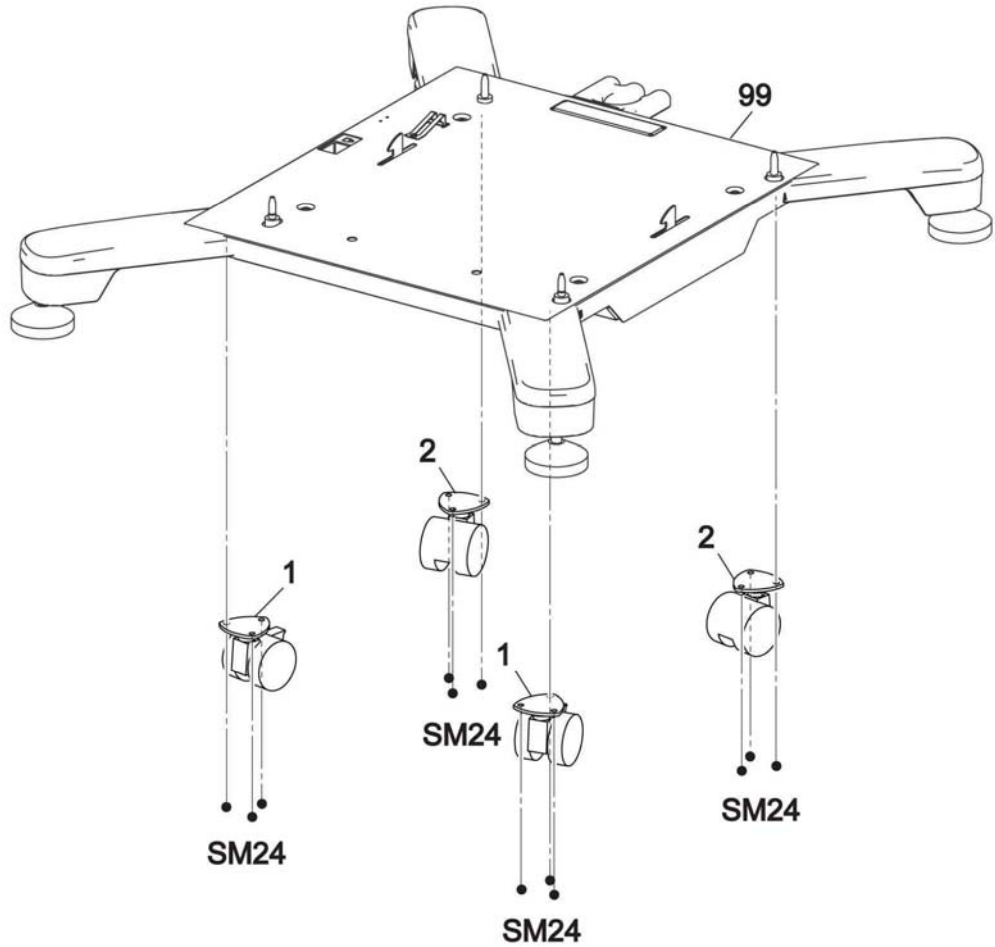
## PL 30.2 Caster

Item	Part	Description
1	-	Caster (with lock)
2	-	Caster (without lock)

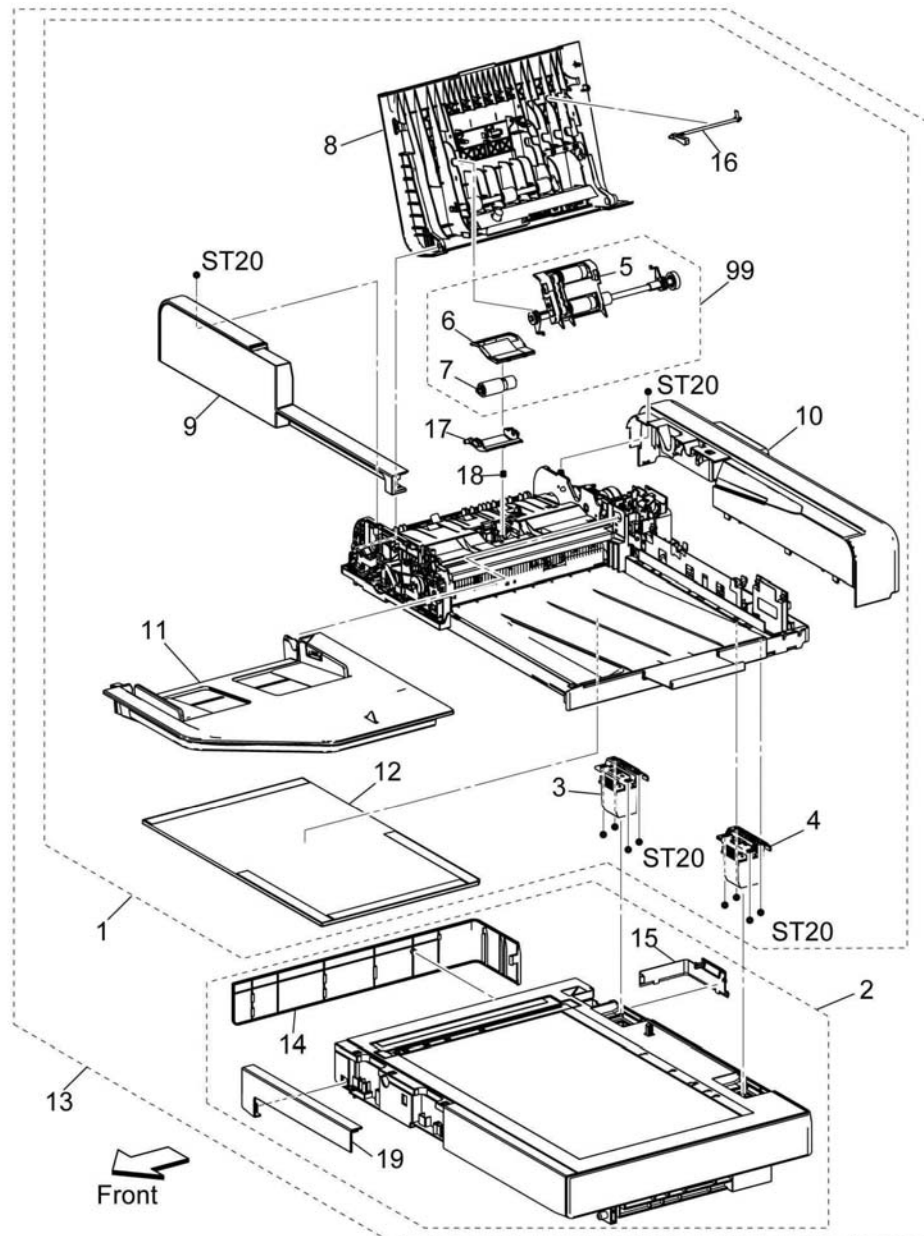
## PL 50.1 Scanner (MFP only)

16	120E35681	DADF actuator <a href="#">REP 50.7</a>
17	-	Holder separator DADF (P/O <a href="#">PL 50.1 Item 1</a> )
18	-	Spring separator DADF (Not Spared)
19	822E35311	Cover front IIT <a href="#">REP 50.8</a>
99	-	Kit DADF feed roll (with 5-7) (P/O <a href="#">PL 50.1 Item 1</a> )

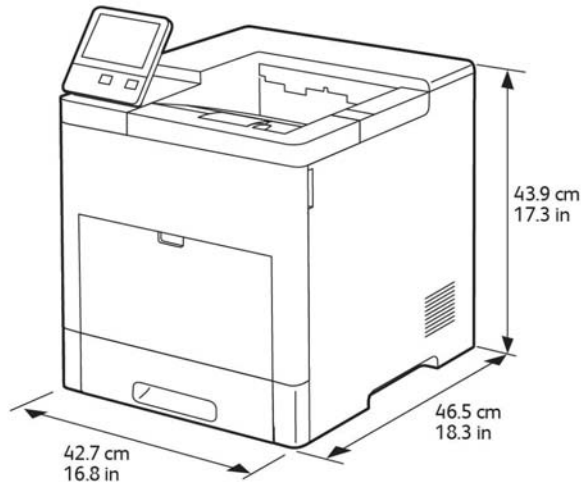
**Figure 1 Standard configuration**

Refer to [Figure 1](#) and [Table 3](#) for the weight and dimensions for standard B600 and B610 printers.

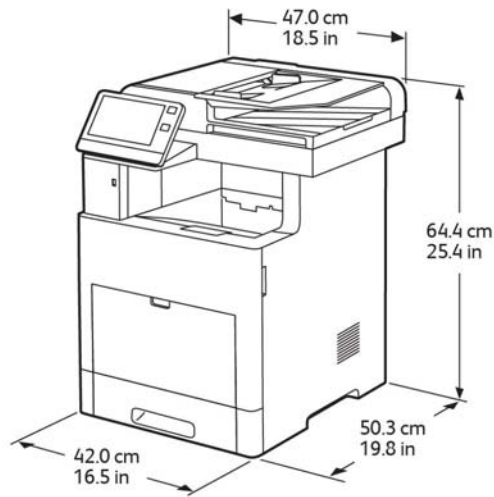
Figure 2 MFP Standard

- B605/B615 MFP: [Figure 2](#) and [Table 6](#)
- B615\_Tall: [Figure 3](#) and [Table 9](#)

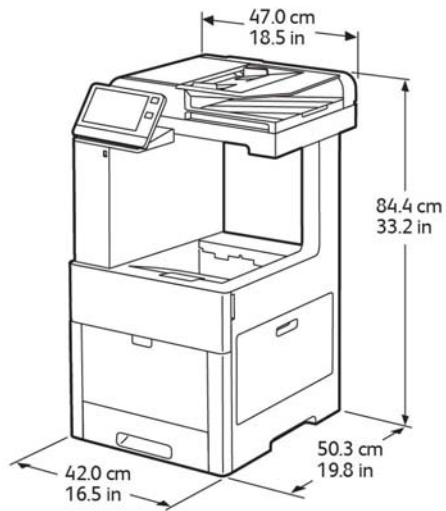
**Figure 3 MFP (B615\_Tall)**

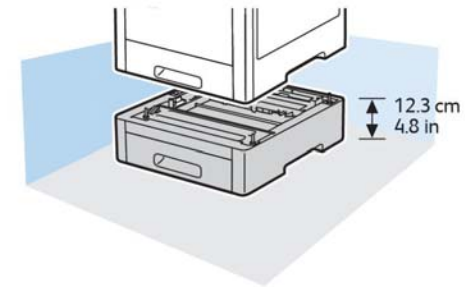
**Figure 4 Optional 550 sheet feeder**

Width	420mm (16.5 in.)
Depth	464.5mm (18.3 in.)
Height	123.5mm (4.8 in.)
Weight	6.6kg (14.6 lb.)

- [Figure 4, Table 10](#): Optional 550 sheet feeder
- [Figure 5, Table 11](#): Caster base with cabinet
- [Figure 6, Table 12](#): Caster stand with HCF
- [Figure 7, Table 13](#), Finisher (B600/ B610)
- [Figure 8, Table 13](#), Finisher (B605/ B615\_Tall)
- [Figure 9, Table 14](#), Mailbox (B600/ B610)
- [Figure 10, Table 14](#), Mailbox (B605/B615)

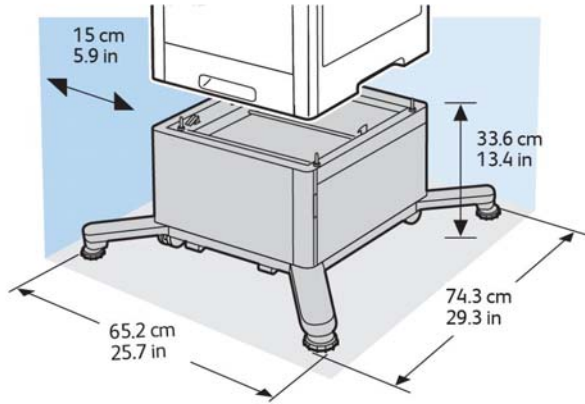
Figure 5 Caster base with cabinet

Width (min)	652mm (25.7 in.)
Width (max)	802mm (31.6 in.)
Depth	743mm (29.3 in.)
Height	336mm (13.4 in.)
Weight (cabinet)	16.6kg (36.6 lb.)
Weight (caster base)	8.5kg (18.8 lb.)

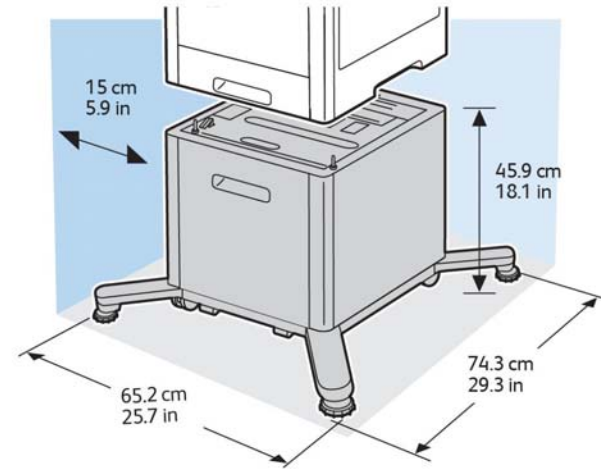
Figure 6 Caster base with HCF

Width (min)	652mm (25.7 in.)
Width (max.)	802mm (31.6 in.)
Depth	743mm (29.3 in.)
Height	459mm (18.1 in.)
Weight (HCF)	19.7kg (43.4 lb.)
Weight (caster base)	8.5kg (18.8 lb.)

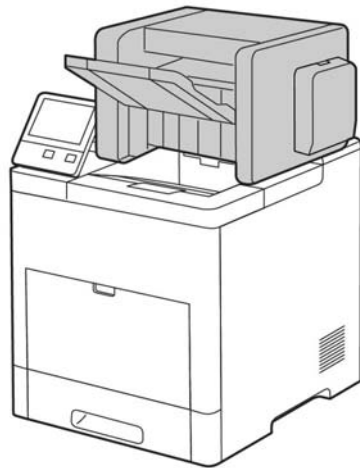
**Figure 7 Finisher (B600/B610 SFP)**

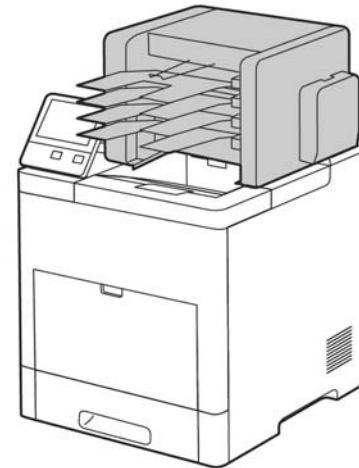
**Figure 9 Mailbox (B600/B610 SFP)**

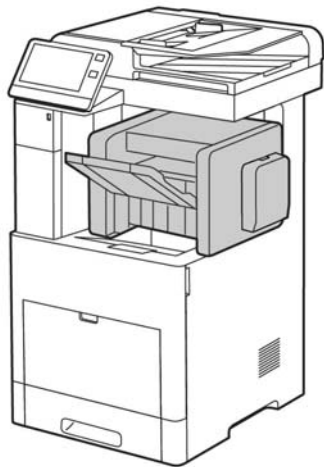
**Figure 8 Finisher (B605/B615\_Tall MFP)**

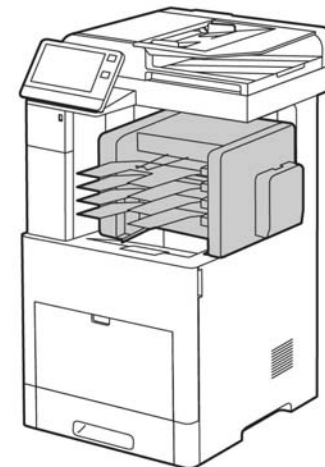
**Figure 10 Mailbox (B605/ B615 MFP Tall)**

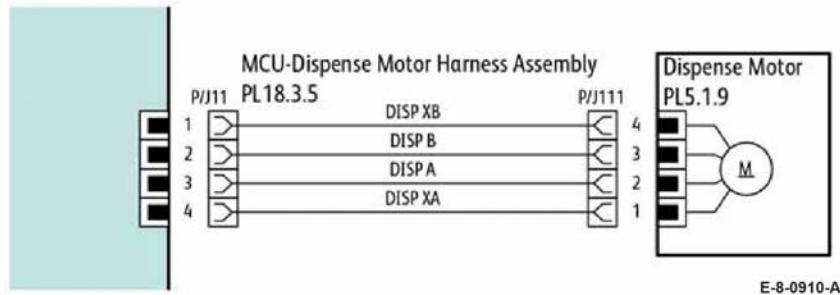
1. Refer to [Figure 1](#) as an example. Disconnect PJ111. Check the +24VDC supply and the phase pulses to GND when the component control code for the motor is entered. If the supply and pulses are present, install a new motor.
2. Check the connectors and wiring to the motor. Repair or install new wiring, as necessary.
3. Disconnect PJ11. Check the +24VDC. If +24VDC is not present, check the power to the PWB. If the power is good, install a new PWB. Check the phase pulses at the PWB. If the phase pulses are not present at the PWB, install a new PWB.

Figure 1 Motor wiring diagram

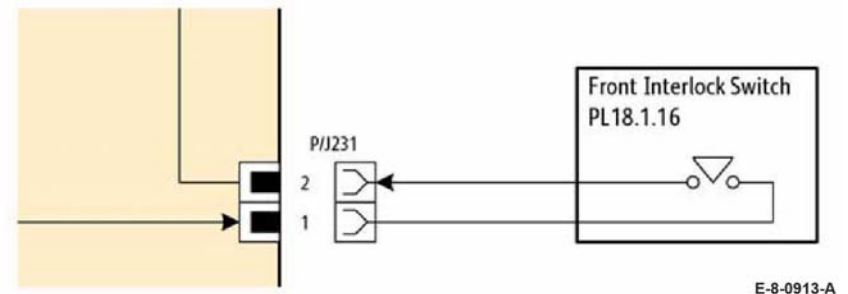
1. Enter dc330 diagnostics and enable the component control code for the switch to test. Actuate the switch. If the display changes, the switch operates correctly. If the display does not change, perform the following steps.
2. Inspect the mechanism intended to actuate the switch. Adjust, repair or install a new part as needed if it is not actuating the switch.
3. Disconnect the switch and measure the resistance between the two connector pins. If it does not change from infinite to 0 ohms as the switch is actuated, install a new switch. If the resistance changes correctly, go to the next step.
4. Check the continuity of the wire harness between the switch and its control PWB. If open, repair or install a new harness.
5. If the switch and wire harness have tested good, install a new PWB that the switch is connected to.

Figure 1 Switch wiring diagram

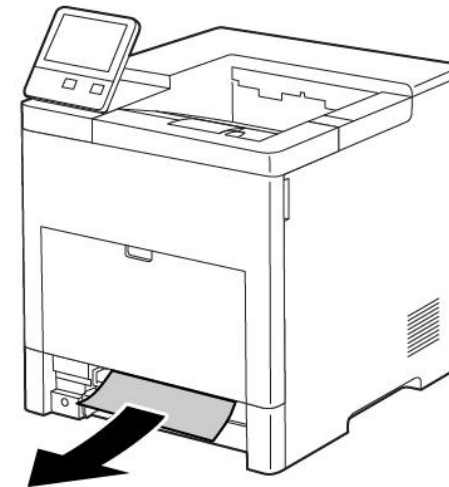
Figure 1 Clear the media path and output tray (SFP shown)

1. Refer to the following figures to clear the media path and output trays.
  - Figure 1 SFP
  - Figure 2 MFP
  - Figure 3 MFP with optional 550 sheet feeder
  - Figure 4 Remove the optional feeder from the printer

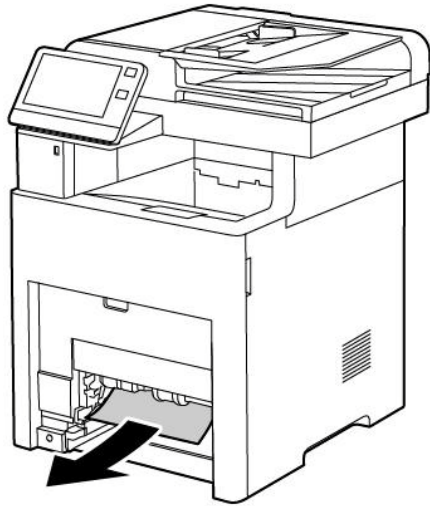
**Figure 2 Clear the media path and output tray (MFP)**

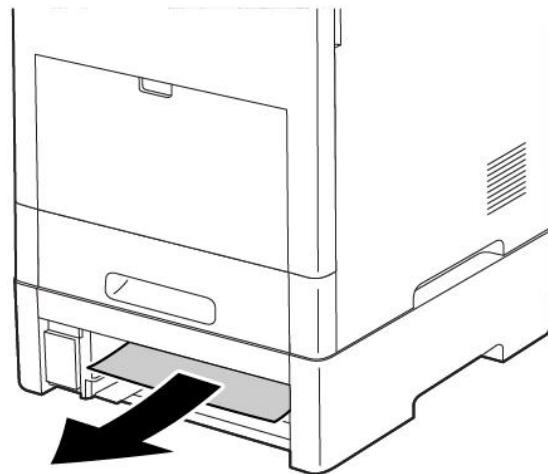
**Figure 3 Clear the media path and output tray (printer with optional feeder)**

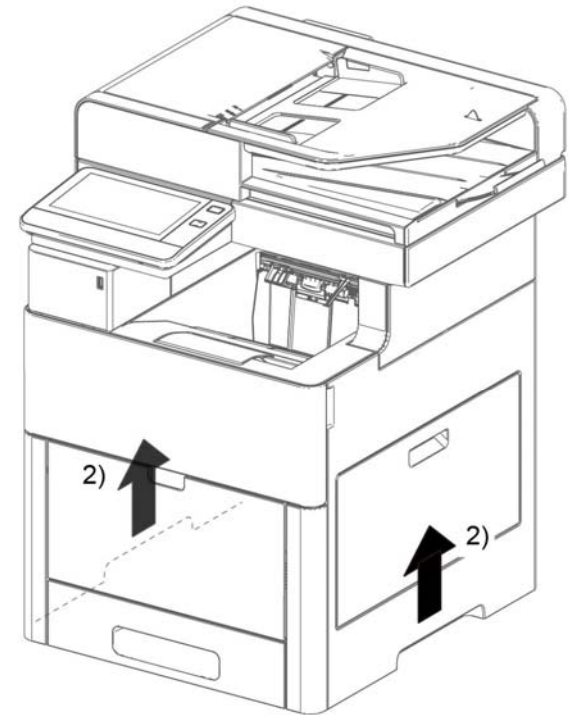
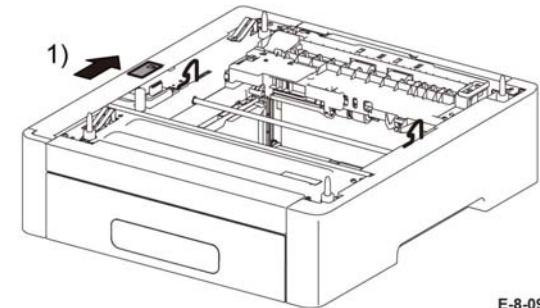
2. Refer to [Figure 4](#) to locate and toggle the slider switch to the unlocked position before separating the printer and optional trays.

**Figure 4 Separate optional feeder assembly from the printer**

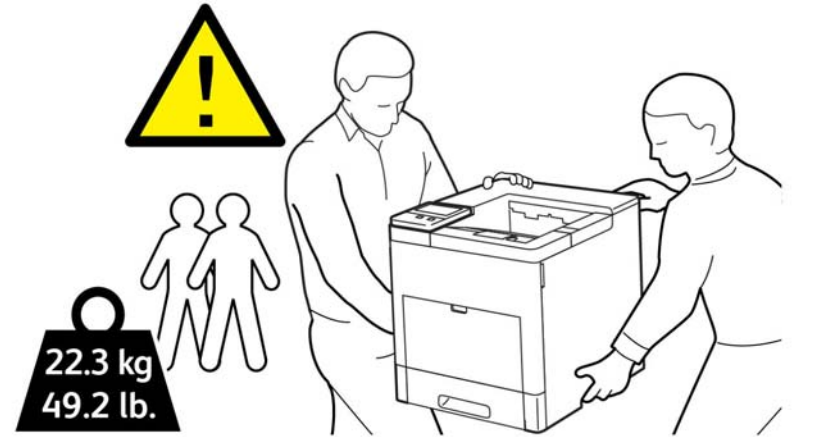
Figure 3 Printer Lifting Technique (SFP)

7. Lift and carry the printer as shown in Figure 3 and Figure 4.

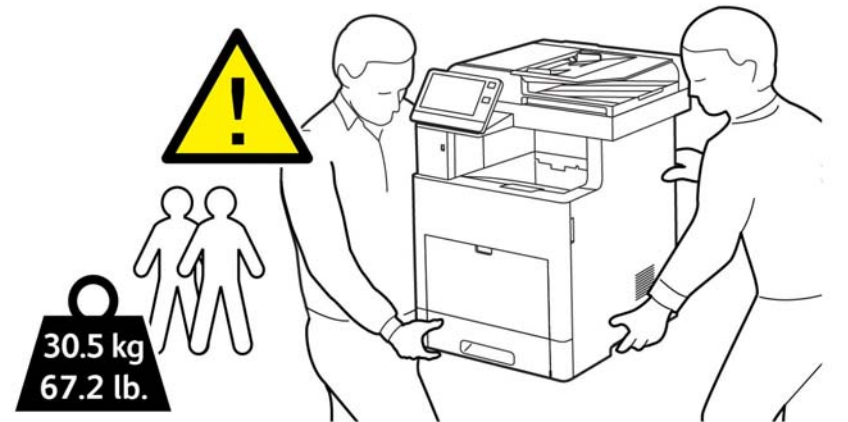
Figure 4 Printer Lifting Technique (MFP)

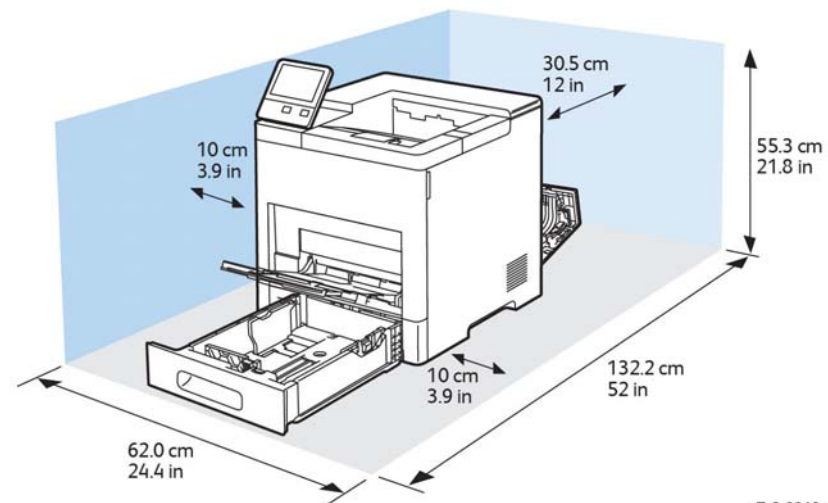
Figure 1 SFP standard

SFP Standard
Width	870mm (34.3 in.)
Depth	1322mm (52 in.)
Height	553mm (21.8 in.)

Refer to [Figure 1](#) and [Table 1](#) for total clearance space requirements for the B600 and B610 SFPs. Refer to [Figure 2](#) and [Table 2](#) for space requirements for the optional 550 sheet feeder. Refer to [Figure 3](#) and [Table 3](#) for the optional finisher.
