# VersaLink® B600/B610 Printer and B605/B615 Multifunction Printer Service Manual

Xerox® VersaLink® B600 Family MFP Service Manual

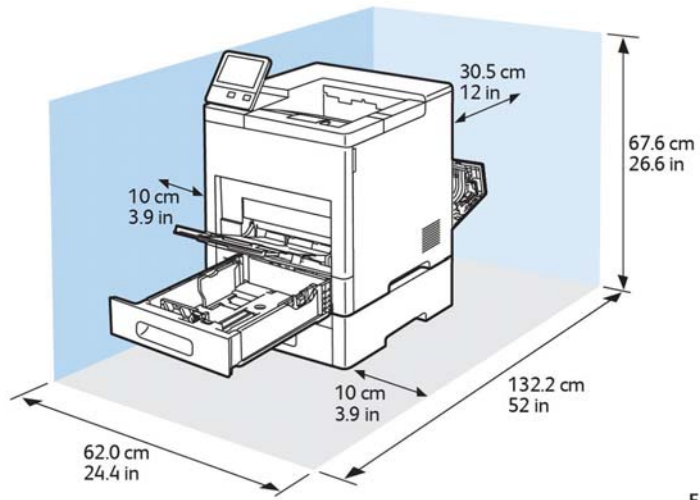
Figure 2 SFP with optional 550 sheet feeder

Width	870mm (34.3 in.)
Depth	1322mm (49.8 in.)
Height	676mm (26.6 in.)

Refer to [Figure 1](#) and [Table 1](#) for total clearance space requirements for the B600 and B610 SFPs. Refer to [Figure 2](#) and [Table 2](#) for space requirements for the optional 550 sheet feeder. Refer to [Figure 3](#) and [Table 3](#) for the optional finisher.

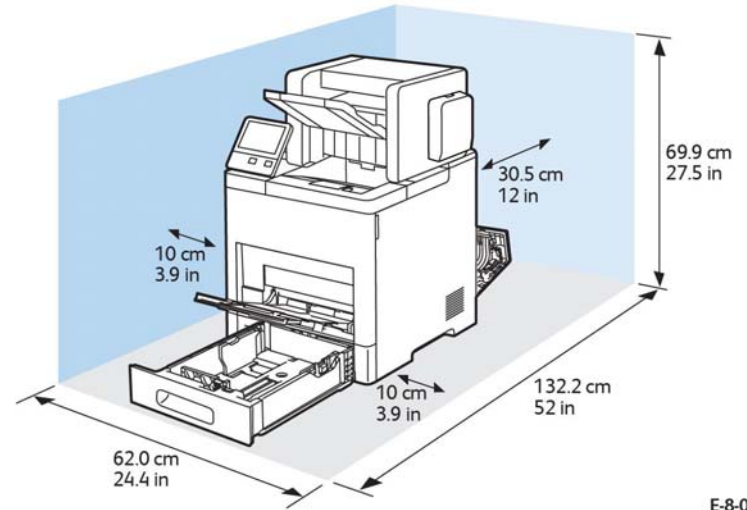
Figure 3 SFP with optional finisher

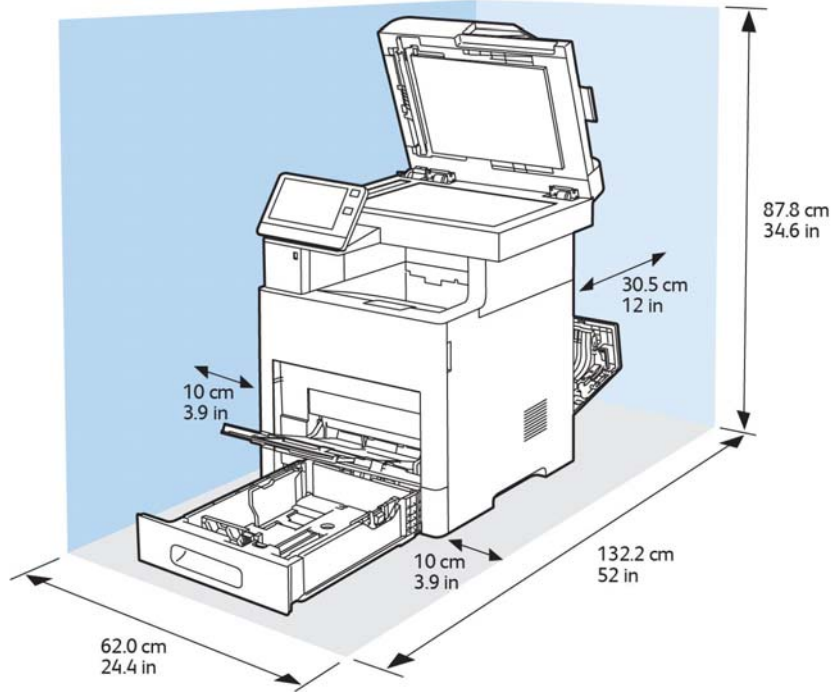
Figure 4 MFP Standard

B605 MFP	Optional 550-Sheet Feeder Dimensions	Optional HCF Dimensions
Width	470mm (18.5 in.)	420mm (16.5 in.)	742mm (28.5 in.)
Depth	506mm (19.9 in.)	465mm (18.3 in.)	772mm (30.4 in.)
Height	643mm (25.3 in.)	148mm (5.8 in.)	459mm (18.1 in.)
Weight	35mm (77.2 lb.)	6.6kg (14.6 lb.)	19.7kg (43.4 lb.)

- MFP Standard: [Figure 4](#) and [Table 4](#)
- MFP Tall: [Figure 5](#) and [Table 5](#)
- MFP\_Tall (space requirements) with and without the optional 550-sheet feeder: [Table 6](#)
- Optional 550-sheet feeder: [Figure 6](#) and [Table 7](#)
- Optional caster stand with HCF: [Figure 7](#) and [Table 8](#)

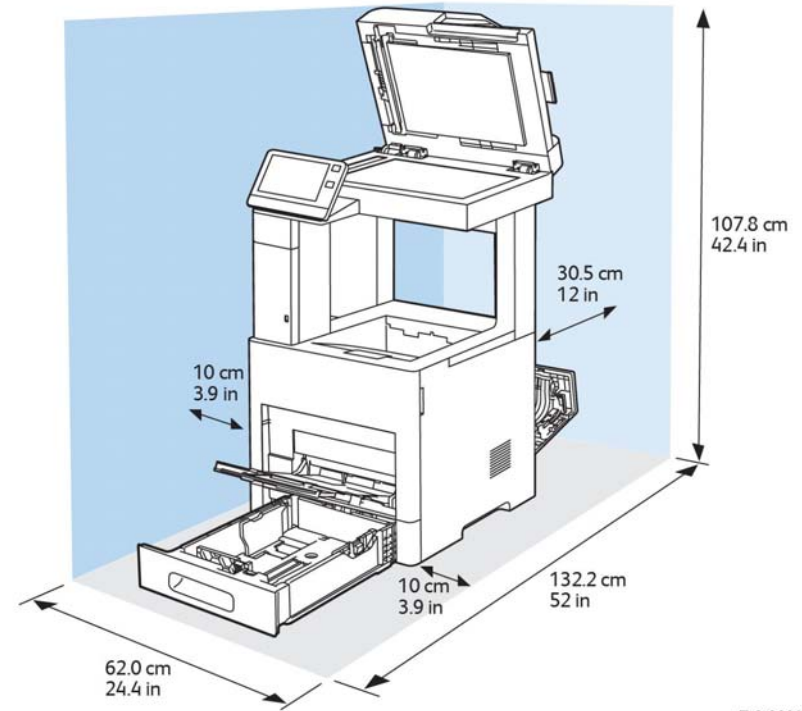
Figure 5 MFP B615\_tall

Configurations without the Optional 550-Sheet Feeder	Optional 550-Sheet Feeder Dimensions
Width	870mm (34.3 in.)	420mm (16.5 in.)
Depth	1322mm (52 in.)	465mm (18.3 in.)
Height	1078mm (34.3 in.)	148mm (5.8 in.)

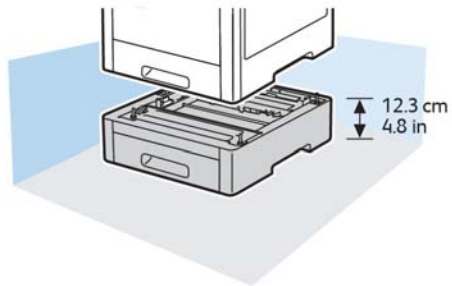
Figure 6 Optional 550 sheet feeder

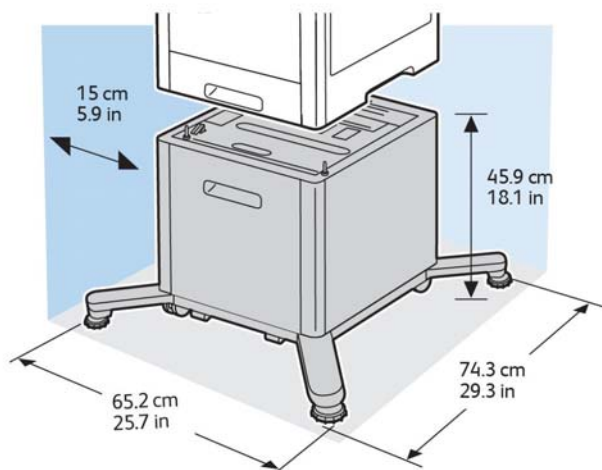
Figure 7 Optional caster stand with HCF

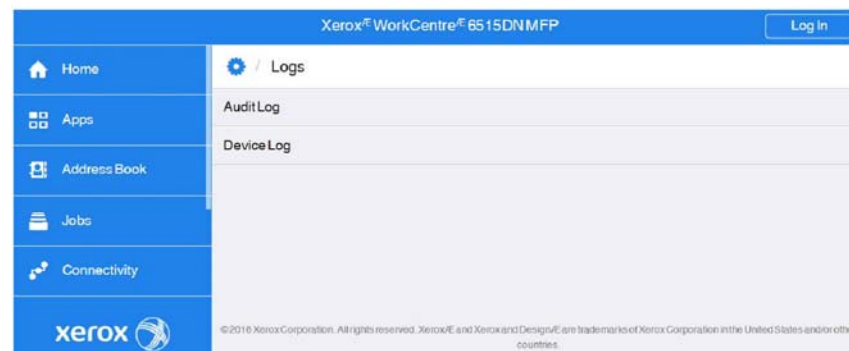
4. Navigate to:**System>Security>SSL/TLS Settings**, to enable HTTP-SSL/TLS communication.
5. Activate the logging tool: **System>Logs** Figure 2.
  - The following window appears:

Figure 2 Logs menu

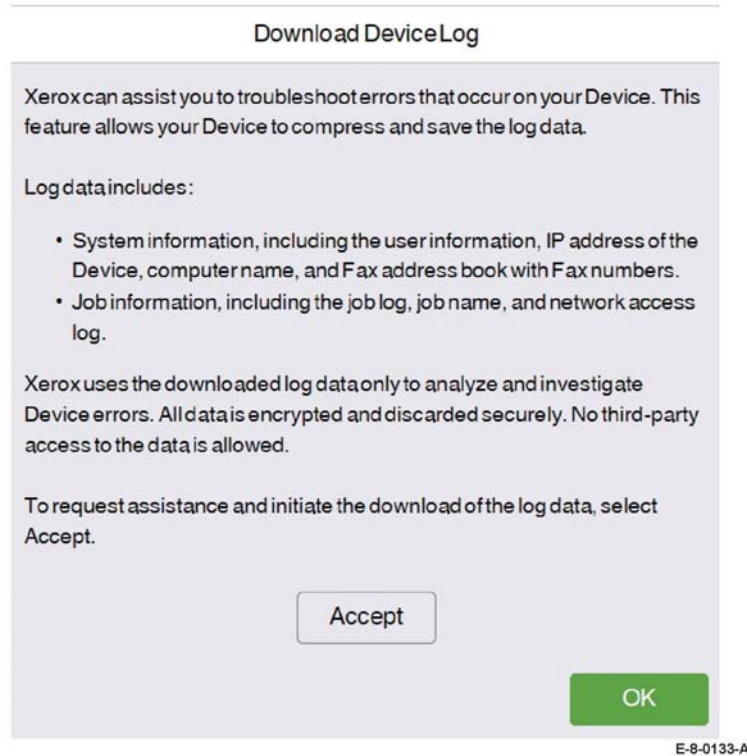
7. Collect the device log. Select **Device Log** from the logs menu.
  - The device log dialog box appears, [Figure 3](#).

**Figure 3 Device Log Dialog Box**

- a. Click **Accept**. Collect the device log.
  - b. The collected device log file (.dat) is saved.
8. Send the collected logs as requested to the Service Support team.

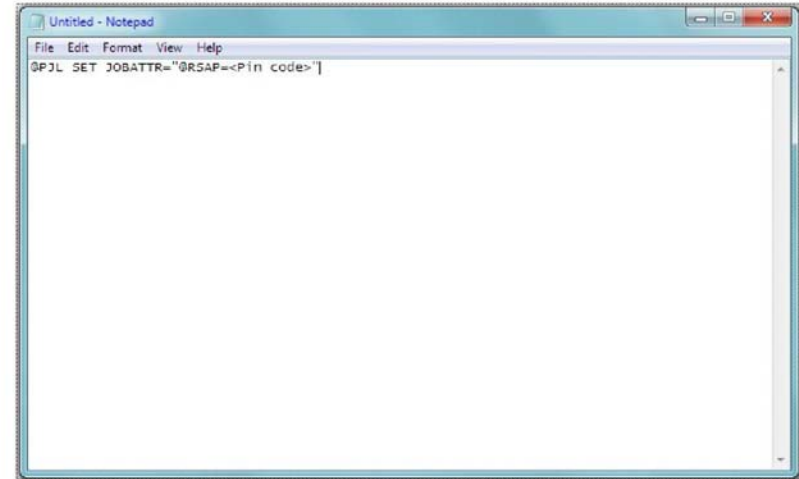
F-1-0405-A

1. Create a PIN code using the administrator password reset tool.
  - a. Run the administrator password reset tool.
  - b. Enter the serial number of the device with no punctuation or spaces.
  - c. Enter the total page count from the device.
  - d. Press **Calculate**.
  - e. Note the 12 digit reset code.
2. Create a reset file using Windows Notepad.
  - a. **Windows 7**
    - Go to: 'Start' >'All Programs' >'Accessories' >'Notepad'.
  - b. **Windows 8 or 10**
    - In Search window (next to the Start button or Windows icon) type 'Notepad' then select 'Notepad' from the list.
  - c. Copy the line below paste into the new Notepad text area, [Figure 1](#). **@PJL SET JOBATTR="@RSAP=<Pin code>"**
    - Replace <Pin code> with the actual 12 digit PIN code that you generated from the SA Password tool.
    - Example of PIN code: **@PJL SET JOBATTR="@RSAP=123456789123"**.

Figure 1 Notepad example

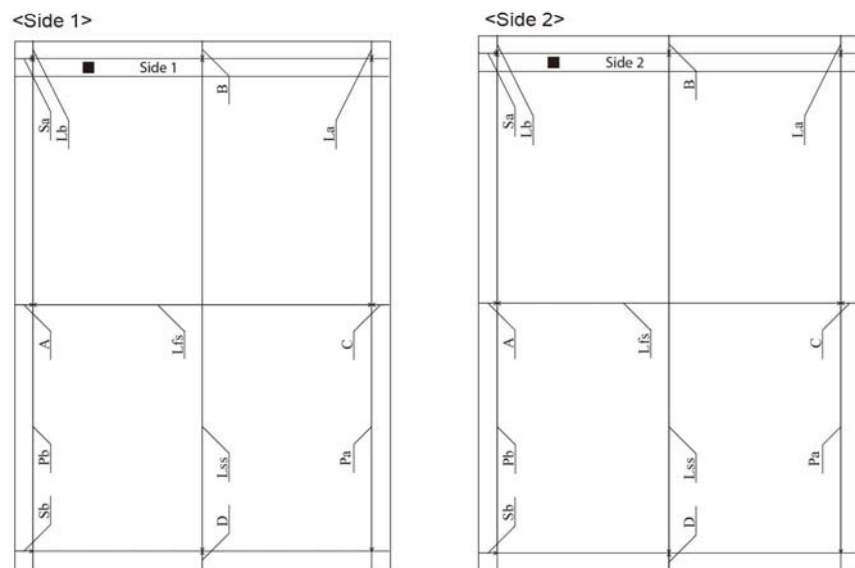
E-8-0717-A

1. Enter Diagnostics, **GP 1**.
2. Touch **dC126 System Registration Adjustment**.  
The System Registration Adjustment screen is displayed.
3. Select **Paper Supply**, then choose the adjusting tray.
4. Select **Printout Settings**, then touch **Print**. to print the test pattern (Figure 1).

Figure 1 dC126 System registration adjustment test pattern

**NOTE:** The A, B, C and D locations marked on the test pattern indicate the distance from the test pattern image to the paper's edge.

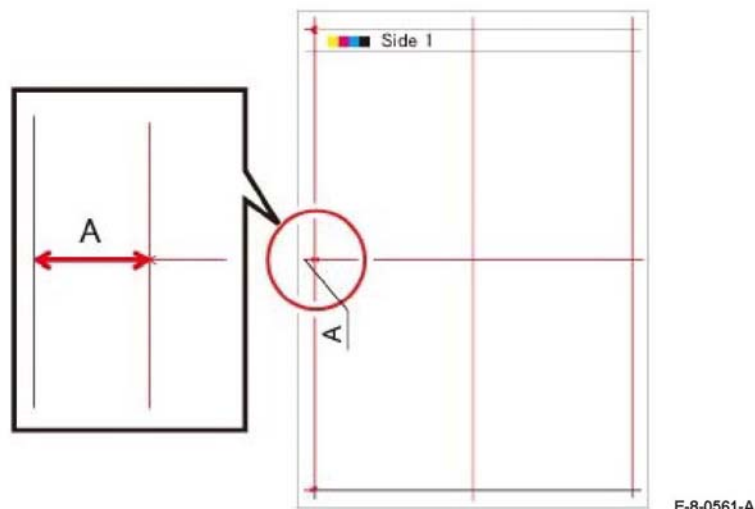
E-8-0561-A

1. Using the test pattern chart which was output from the tray requiring adjustment, measure the length (in millimeters) of "A" on the printed test pattern Side 1 (Figure 2).

Figure 2 Measurement length of A in side 1

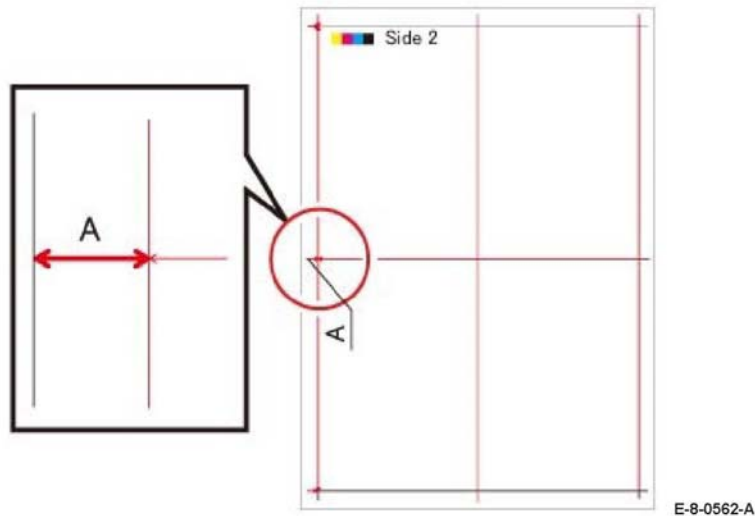
Figure 3 Measurement length of A in side 2

3. Touch **Side Registration**.
4. Select **Adjusted Side** (ex. Side 1).
5. Touch +/- to enter the value of A for side 1 which was measured earlier, or touch A to open a keypad on which to enter a value.
6. Select **Adjusted Side** (ex. Side 2).
7. Touch +/- to enter the value of A for side 2 which was measured earlier, or touch A to open a keypad on which to enter a value.
8. After setting values for side 1 and side 2, touch **Adjust**.
9. Exit Diagnostics, [GP 1](#).

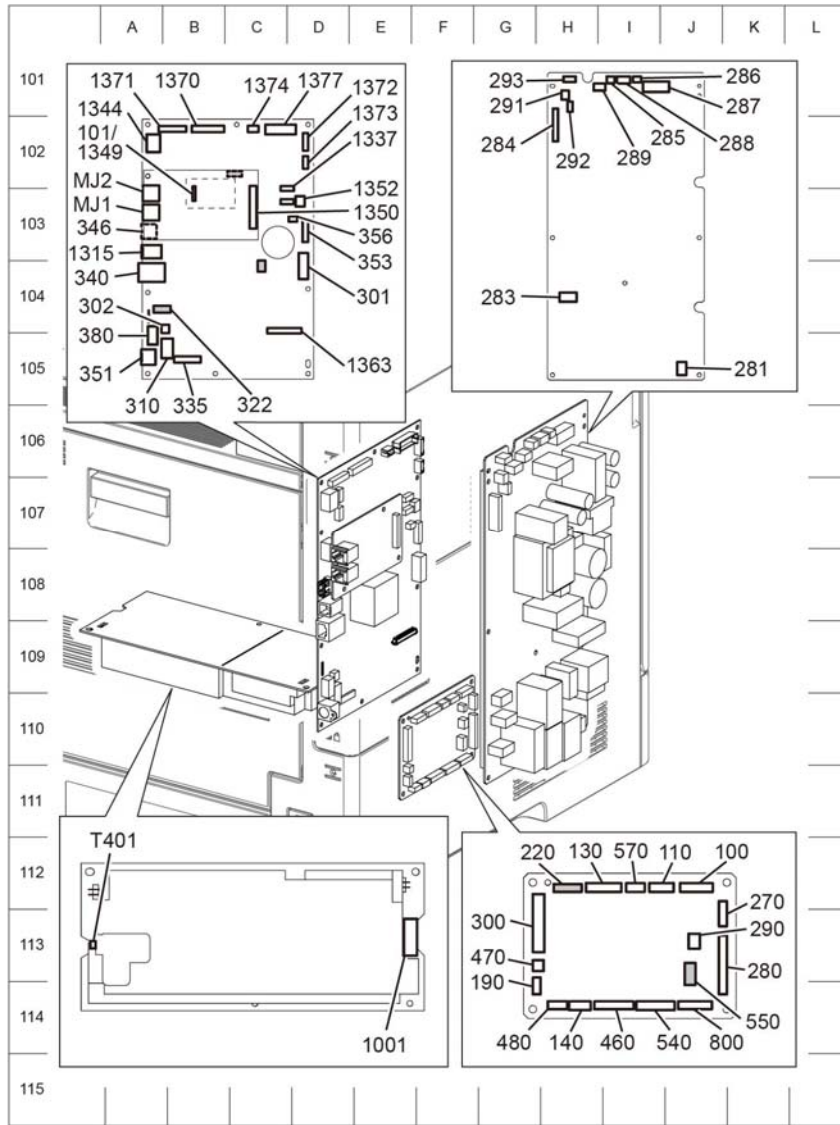
E-8-0002-A

Figure 1 MFP STD (1 of 4)

P/J	Map	Coordinates	Connection
P/J1370	Figure 1	B-102	ESS MFP PWB and DADF/IIT harness assembly
P/J1371	Figure 1	B-102	ESS MFP PWB and DADF/IIT harness assembly
P/J1372	Figure 1	D-102	ESS MFP PWB and DADF/IIT harness assembly
P/J1373	Figure 1	D-102	ESS MFP PWB and DADF/IIT harness assembly
P/J1374	Figure 1	C-102	ESS MFP PWB and DADF/IIT harness assembly
P/J1377	Figure 1	C-102	ESS MFP PWB and DADF/IIT harness assembly
P/JMJ1	Figure 1	A-103	Network port (line)
P/JMJ2	Figure 1	A-103	Network port (phone)
P/JT401	Figure 1	A-113	HVPS PWB and bias transfer roll

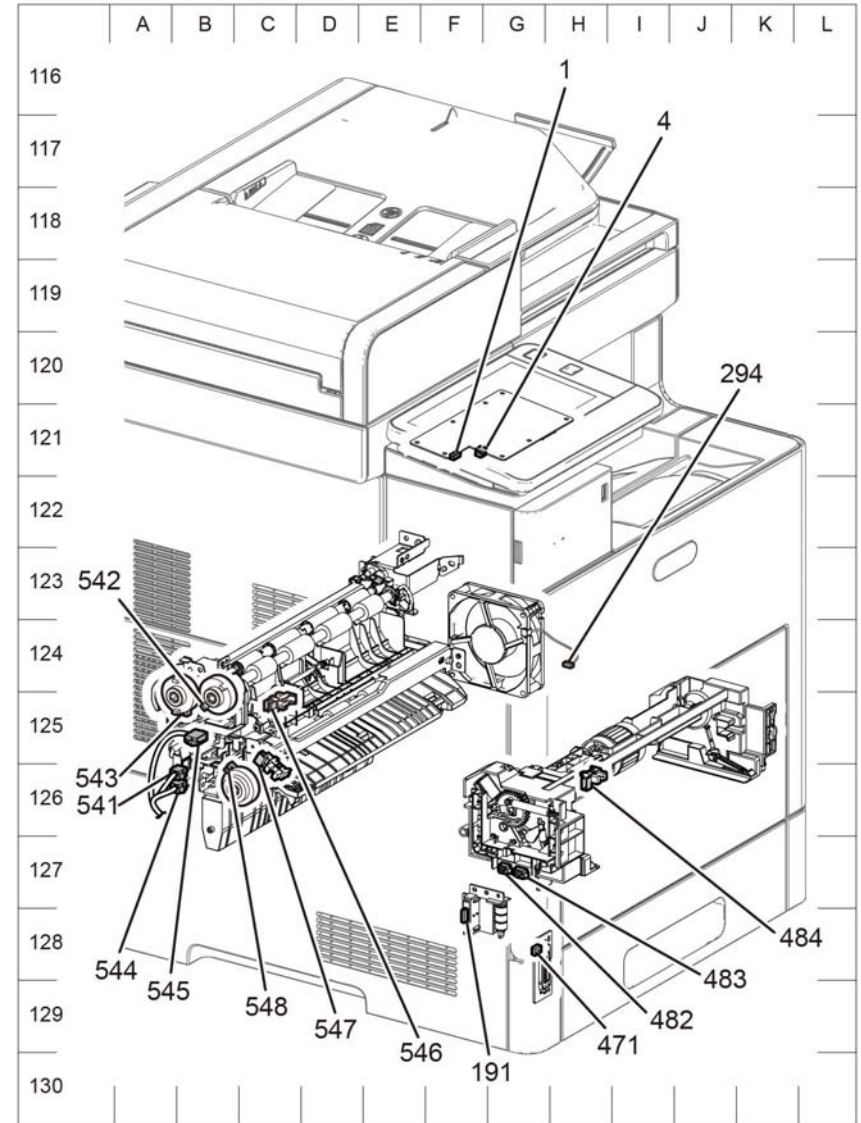
E-8-0004-A

Figure 2 MFP - std (2 of 4)

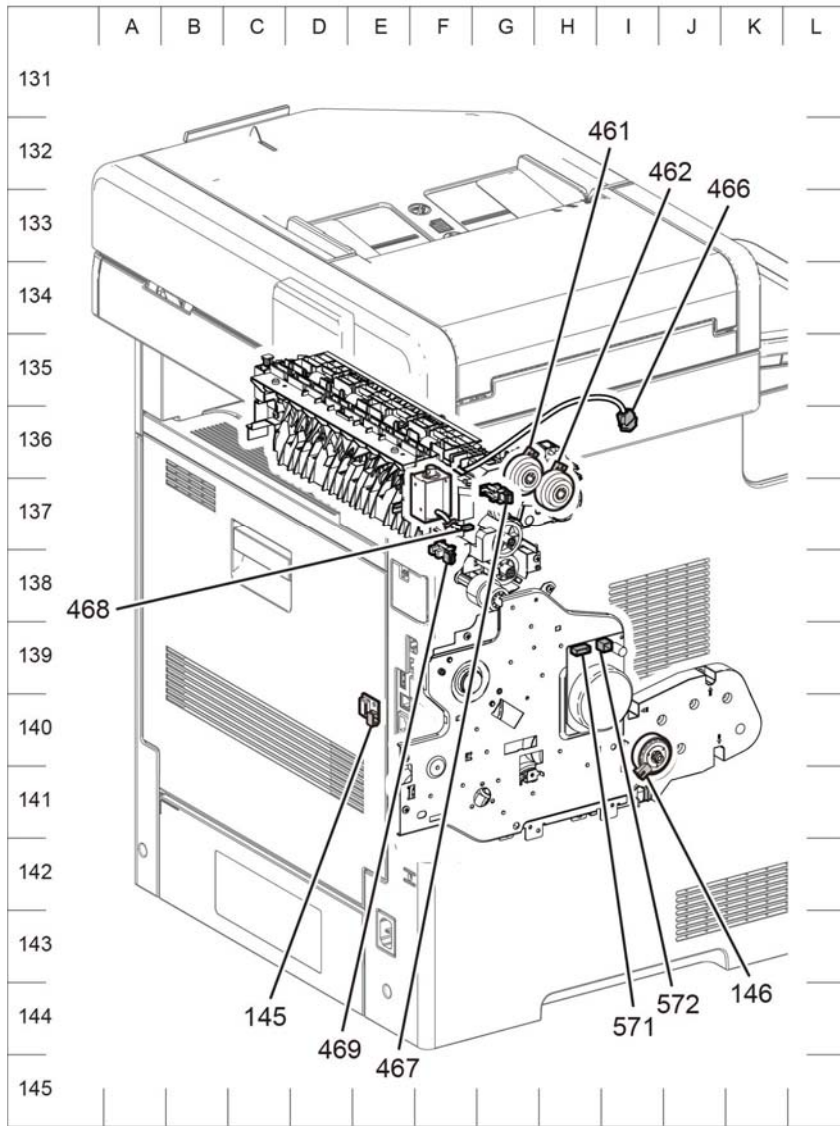
E-8-0005-A

Figure 3 MFP - Std (3 of 4)

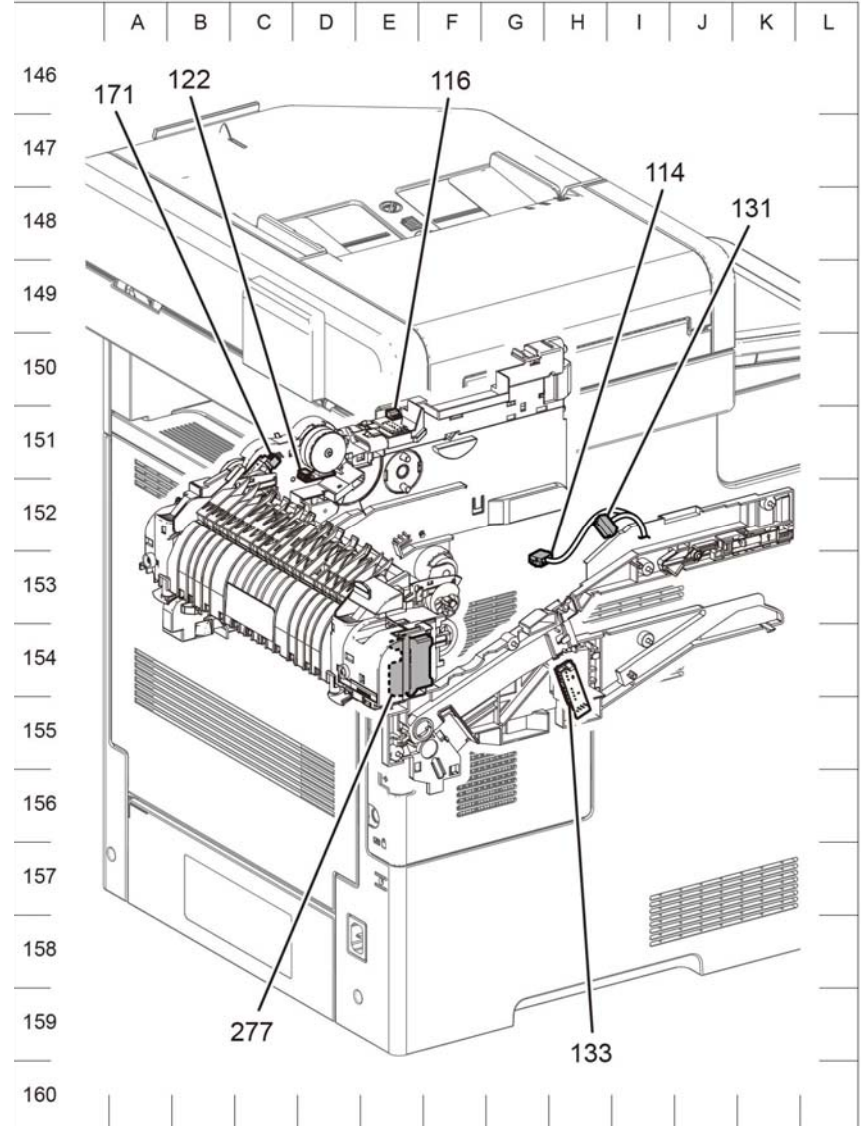
E-8-0006-A

Figure 4 MFP - Std (4 of 4)

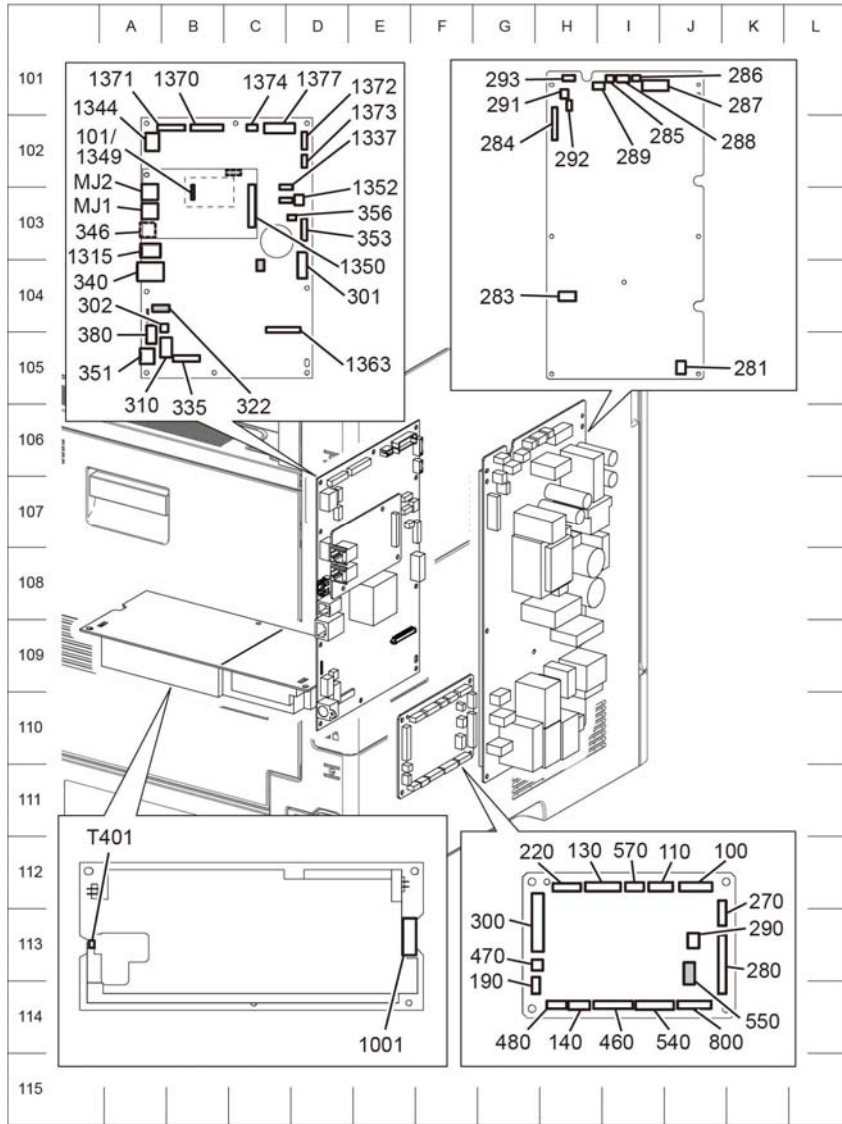
E-8-0008-A

Figure 1 MFP tall (1 of 4)

P/J	Map	Coordinates	Connection
P/J572	Figure 3	I-139	main motor and motor power-MV harness assembly
P/J800	Figure 1	J-114	MCU PWB and OPF-MV harness assembly
P/J801	Figure 1	H-106 (OPT FDR)	OPT feeder and OPF-MV harness assembly
P/J1001	Figure 1	E-113	HVPS PWB and MCU HVPS-MV harness assembly
P/J1315	Figure 1	A-103	USB type B port
P/J1337	Figure 1	C-103	ESS MFP PWB and ICCR USB harness assembly
P/J1344	Figure 1	A-102	ESS MFP PWB and wireless module
P/J1349	Figure 1	B-102	ESS MFP PWB and EMMC card
P/J1350	Figure 1	C-103	Fax PWB and fax harness assembly
P/J1352	Figure 1	D-103	ESS MFP PWB and UI harness assembly
P/J1363	Figure 1	C-104	ESS MFP PWB and LPH MONO head assembly
P/J1370	Figure 1	B-102	ESS MFP PWB and DADF/IIT harness assembly
P/J1371	Figure 1	B-102	ESS MFP PWB and DADF/IIT harness assembly
P/J1372	Figure 1	D-102	ESS MFP PWB and DADF/IIT harness assembly
P/J1373	Figure 1	D-102	ESS MFP PWB and DADF/IIT harness assembly

P/J1374	Figure 1	C-102	ESS MFP PWB and DADF/IIT harness assembly
P/J1377	Figure 1	C-102	ESS MFP PWB and DADF/IIT harness assembly
P/JMJ1	Figure 1	A-103	Network port (line)
P/JMJ2	Figure 1	A-103	Network port (phone)
P/JT401	Figure 1	A-113	HVPS PWB and bias transfer roll

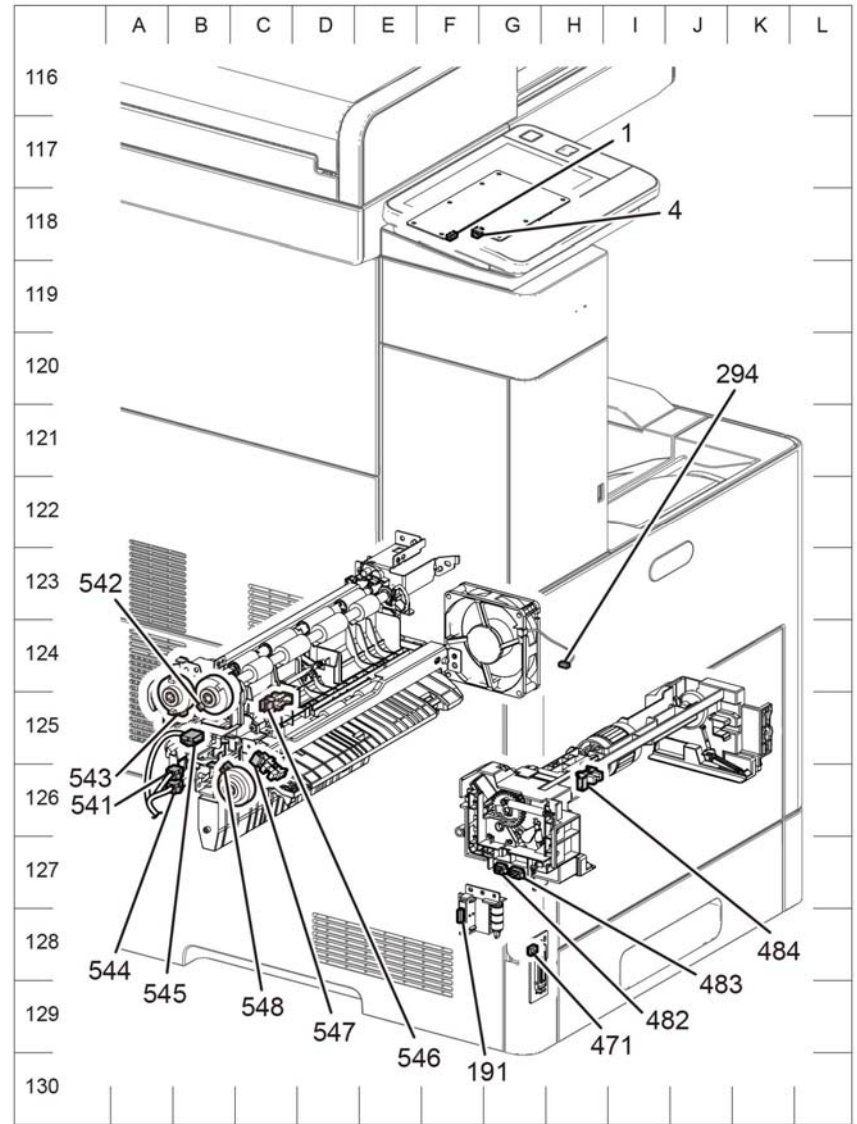
E-8-0010-A

Figure 2 MFP tall (2 of 4)

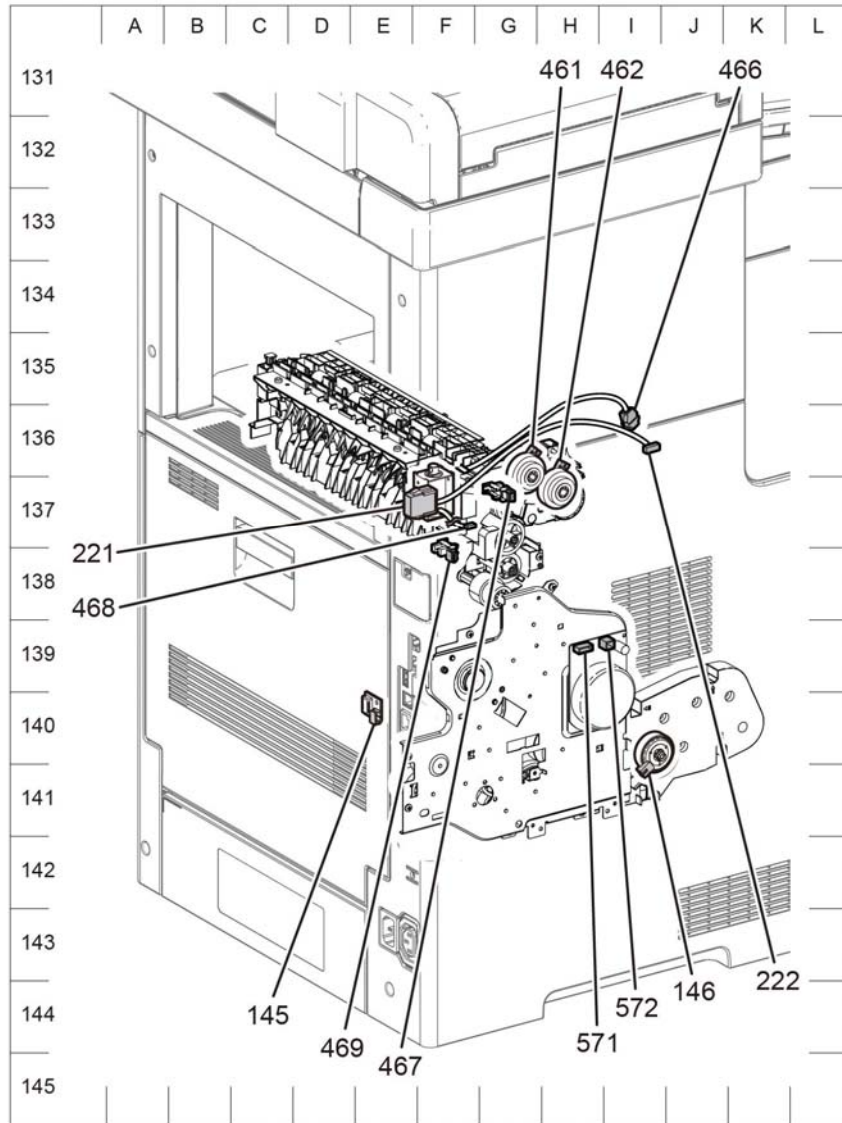
E-8-0011-A

Figure 3 MFP tall (3 of 4)

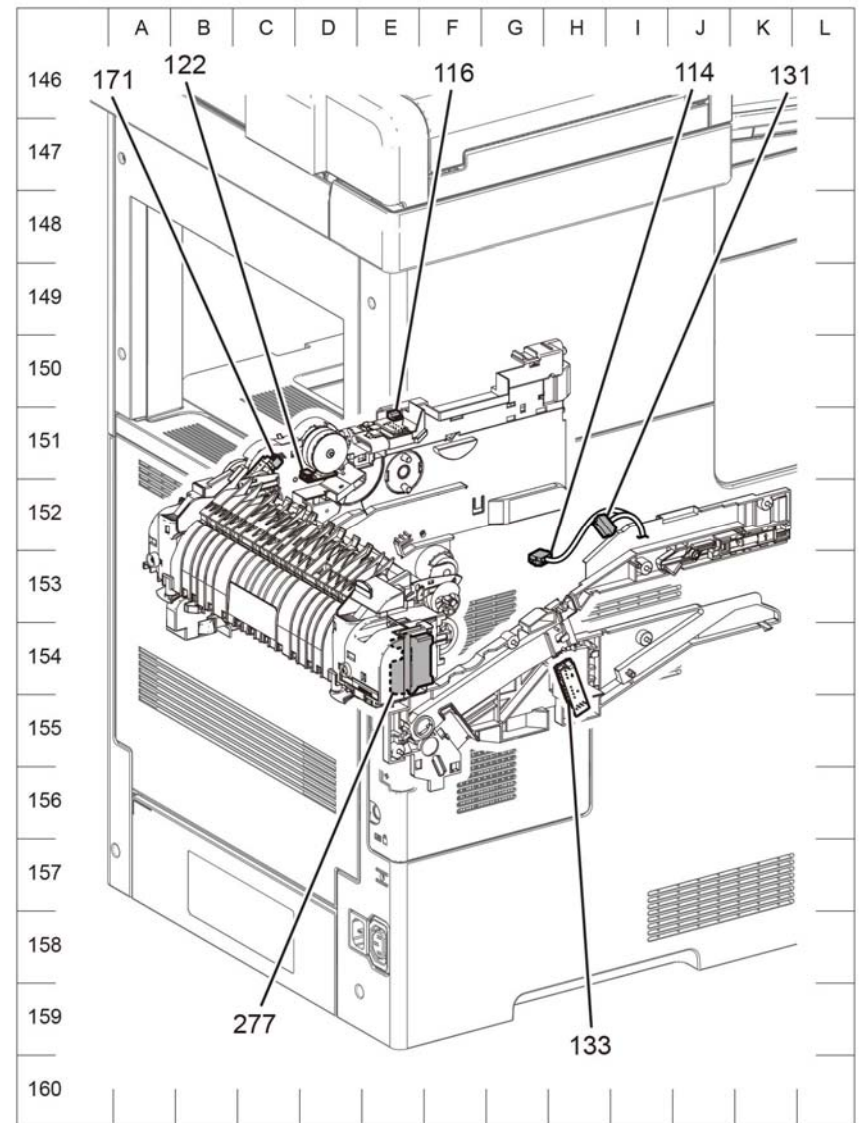
E-8-0012-A

Figure 4 MFP tall (4 of 4)

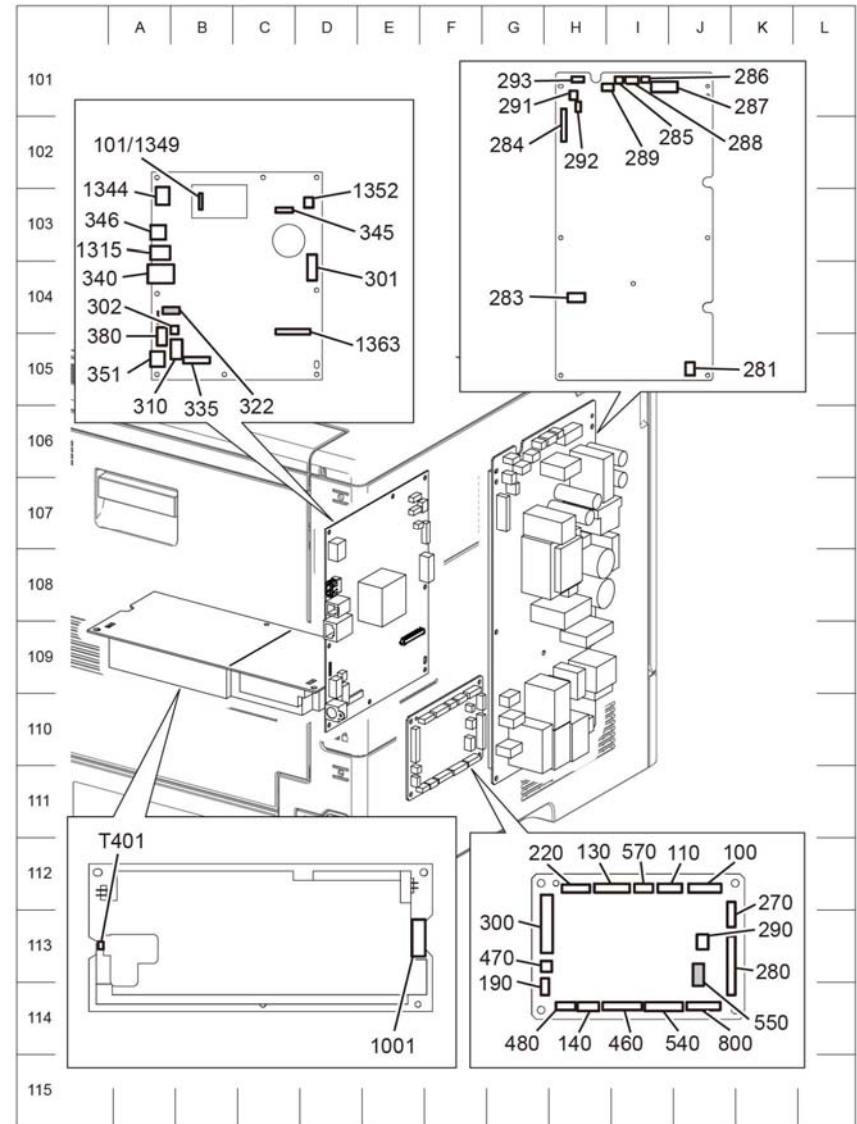
E-8-0014-A

Figure 1 SPF (1 of 4)

P/J	Map	Coordinates	Connection
P/J471	Figure 2	G-128	LED tray PWB and LED harness assembly
P/J480	Figure 1	H-114	MCU PWB and MSI-MV harness assembly
P/J482	Figure 2	G-127	MSI feed solenoid and MSI-MV harness assembly
P/J483	Figure 2	G-127	MSI no paper sensor-C harness assembly and MSI-MV harness assembly
P/J484	Figure 2	H-126	MSI no paper sensor and MSI no paper sensor-C harness assembly
P/J540	Figure 1	I-114	MCU PWB and registration-MV harness assembly
P/J541	Figure 2	B-126	Registration/duplex-C clutch harness assembly and registration-MV harness assembly
P/J542	Figure 2	B-125	Registration clutch and registration/duplex-C harness assembly
P/J543	Figure 2	A-125	Duplex clutch and registration/duplex-C clutch harness assembly
P/J544	Figure 2	B-126	Feed-C clutch harness assembly and registration-MV harness assembly
P/J545	Figure 2	B-125	Registration no paper sensor harness assembly and registration-MV harness assembly

P/J546	Figure 2	C-125	Registration sensor and registration no paper sensor-C harness assembly
P/J547	Figure 2	C-125	No paper sensor and registration no paper sensor-C harness assembly
P/J548	Figure 2	B-125	PH clutch assembly and feed-C clutch harness assembly
P/J550	Figure 1	J-113	Not connected
P/J570	Figure 1	I-112	MCU PWB and main motor-MV harness assembly
P/J571	Figure 3	H-139	Main motor and main motor-MV harness assembly
P/J572	Figure 3	I-139	Main motor and motor power-MV harness assembly
P/J800	Figure 1	J-114	MCU PWB and optional feeder-MV harness assembly
P/J1001	Figure 1	E-113	HVPS PWB and HVPS-MV MCU harness assembly
P/J1315	Figure 1	A-103	USB type B port
P/J1344	Figure 1	A-103	Wireless module and ESS SFP PWB
P/J1349	Figure 1	B-103	ESS SFP PWB and EMMC card
P/J1352	Figure 1	D-103	ESS SFP PWB and UI harness assembly
P/J1363	Figure 1	C-104	ESS SFP PWN and LPH MONO head assembly
P/JT401	Figure 1	A-113	HVPS PWB and bias transfer roll

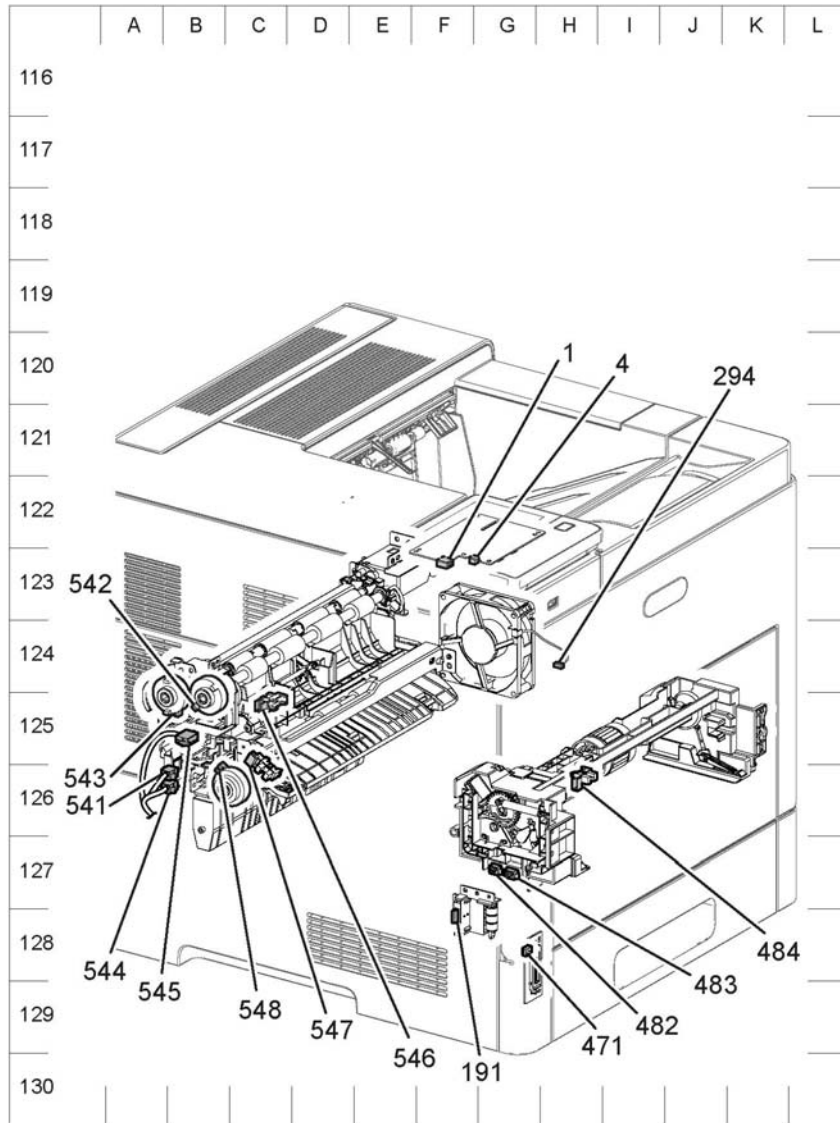
E-8-0016-A

Figure 2 SFP (2 of 4)

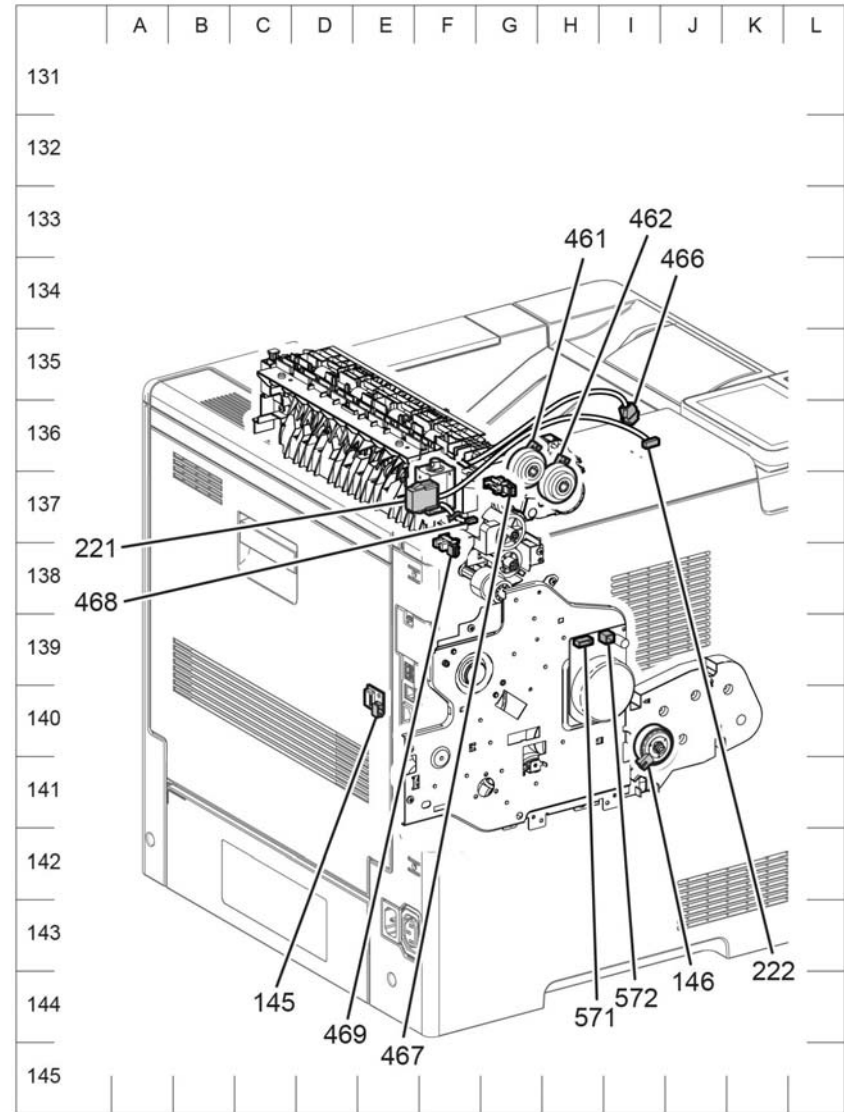
E-8-0017-A

Figure 3 SFP (3 of 4)

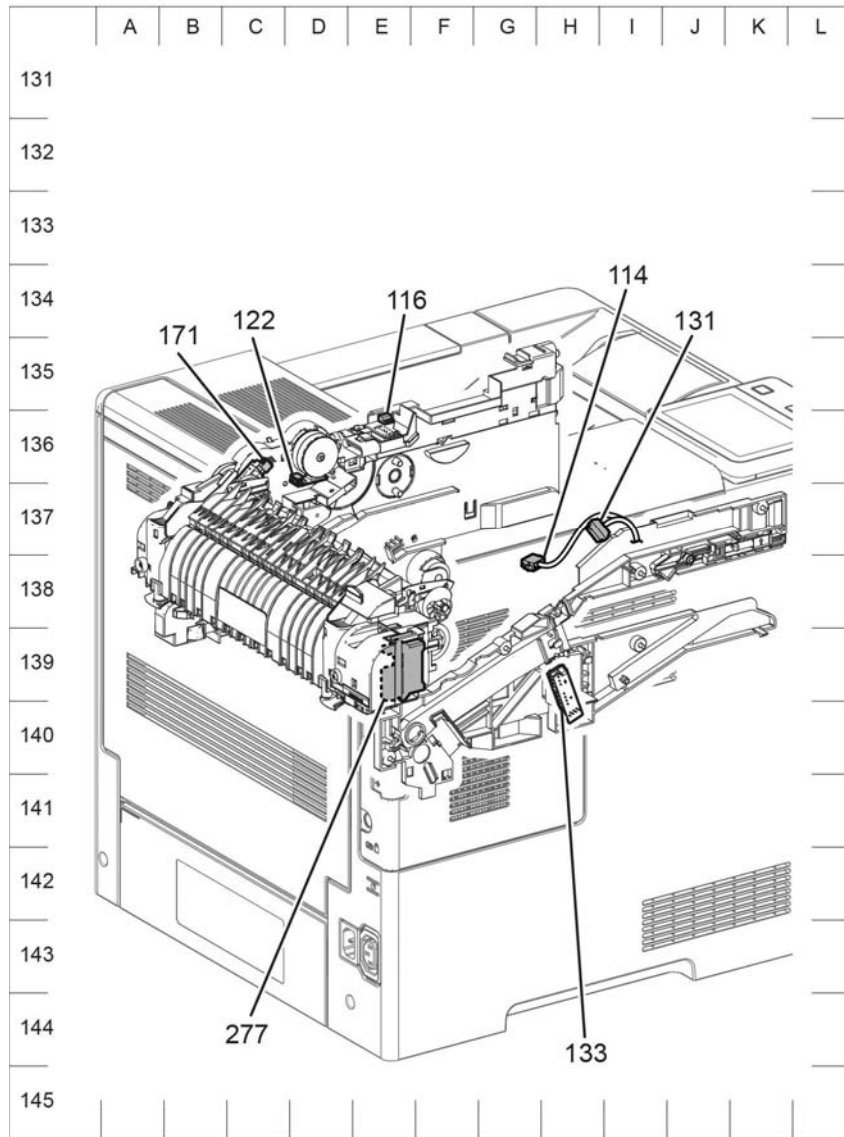
E-8-0018-A

Figure 4 SFP (4 of 4)

1. Locate the P/J connector designator in the first column of [Table 1](#).
2. With this information, refer to the Map column for the figure number.
3. Use the coordinates to find the P/J connector designator's location on the map.

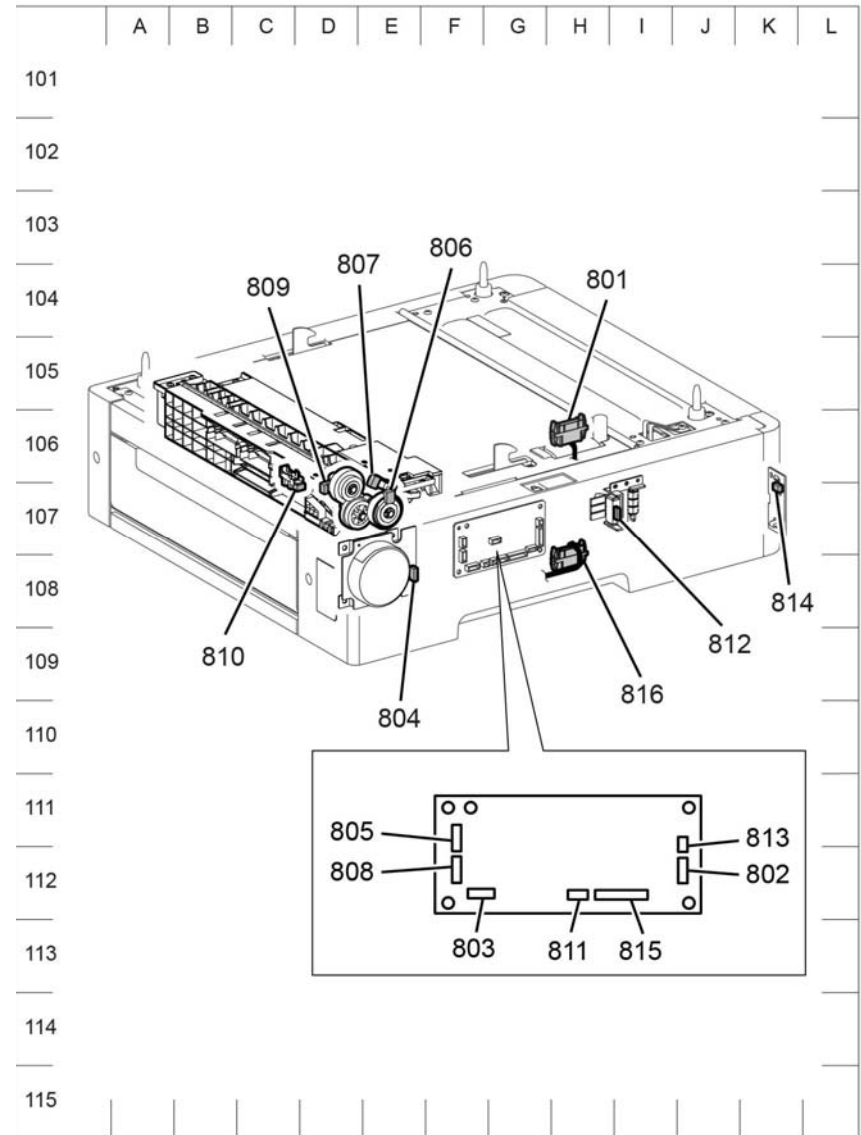
E-8-0019-A

Figure 1 Optional feeder

P/J	Maps	Coordinates	Description
P/J801	Figure 1	H-106	IOT and optional feeder-2C harness assembly
P/J802	Figure 1	J-112	Optional feeder PWBA and harness assembly OPF 2C
P/J803	Figure 1	F-112	Optional Feeder PWBA and optional feeder harness assembly
P/J804	Figure 1	E-108	Main motor harness assembly and harness assembly FDR motor
P/J805	Figure 1	F-111	Optional feeder PWBA and feed harness assembly
P/J806	Figure 1	E-107	Optional feeder feed clutch and feeder harness assembly
P/J807	Figure 1	E-107	Optional feeder no paper sensor and feeder harness assembly
P/J808	Figure 1	F-112	Optional feeder PWB and turn harness assembly
P/J809	Figure 1	D-106	Optional feeder take away clutch and turn harness assembly
P/J810	Figure 1	D-106	Optional feeder paper path sensor and turn harness assembly
P/J811	Figure 1	H-112	Optional feeder PWB and size harness assembly
P/J812	Figure 1	I-107	Optional feeder size switch assembly and size harness assembly

P/J813	Figure 1	J-112	Optional feeder PWB and LED harness assembly
P/J814	Figure 1	K-106	LED tray assembly and LED harness assembly
P/J815	Figure 1	I-112	Optional feeder PWB and feeder drawer harness assembly
P/J816	Figure 1	H-107	Succeeding optional feeder and feeder drawer harness assembly

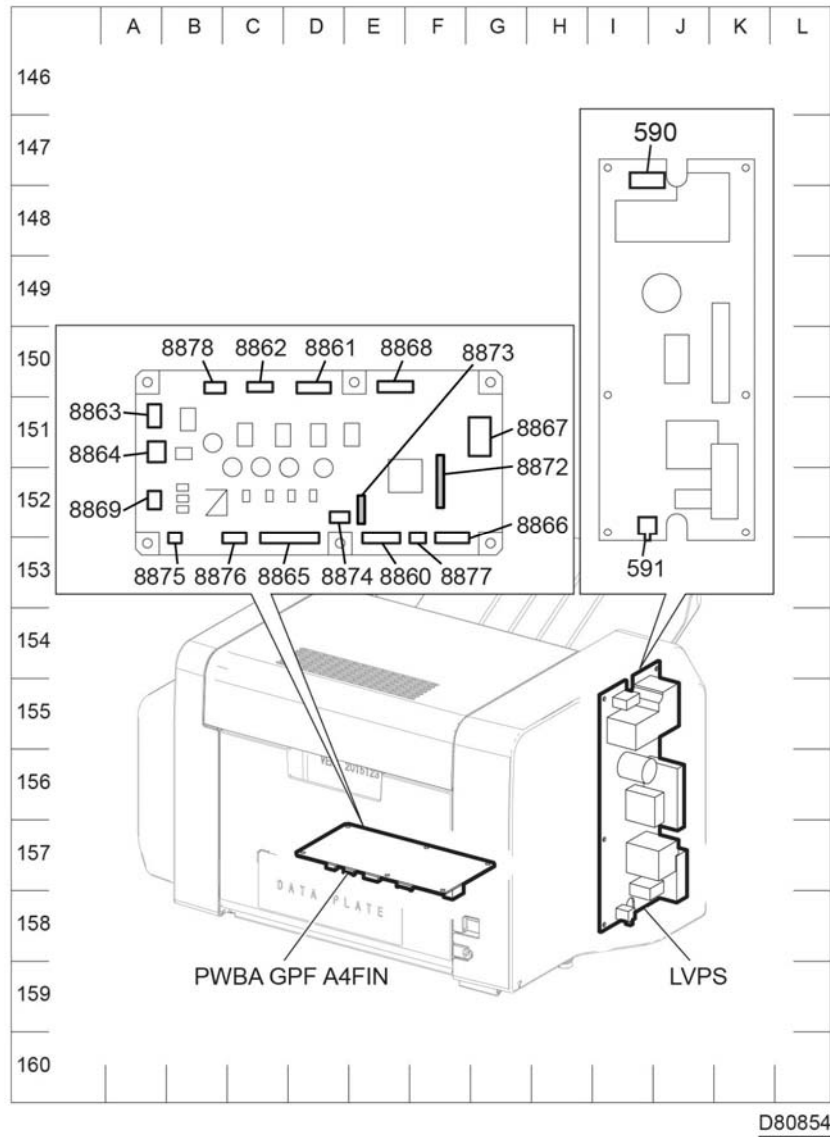
Figure 1 Finisher P/J layout diagram

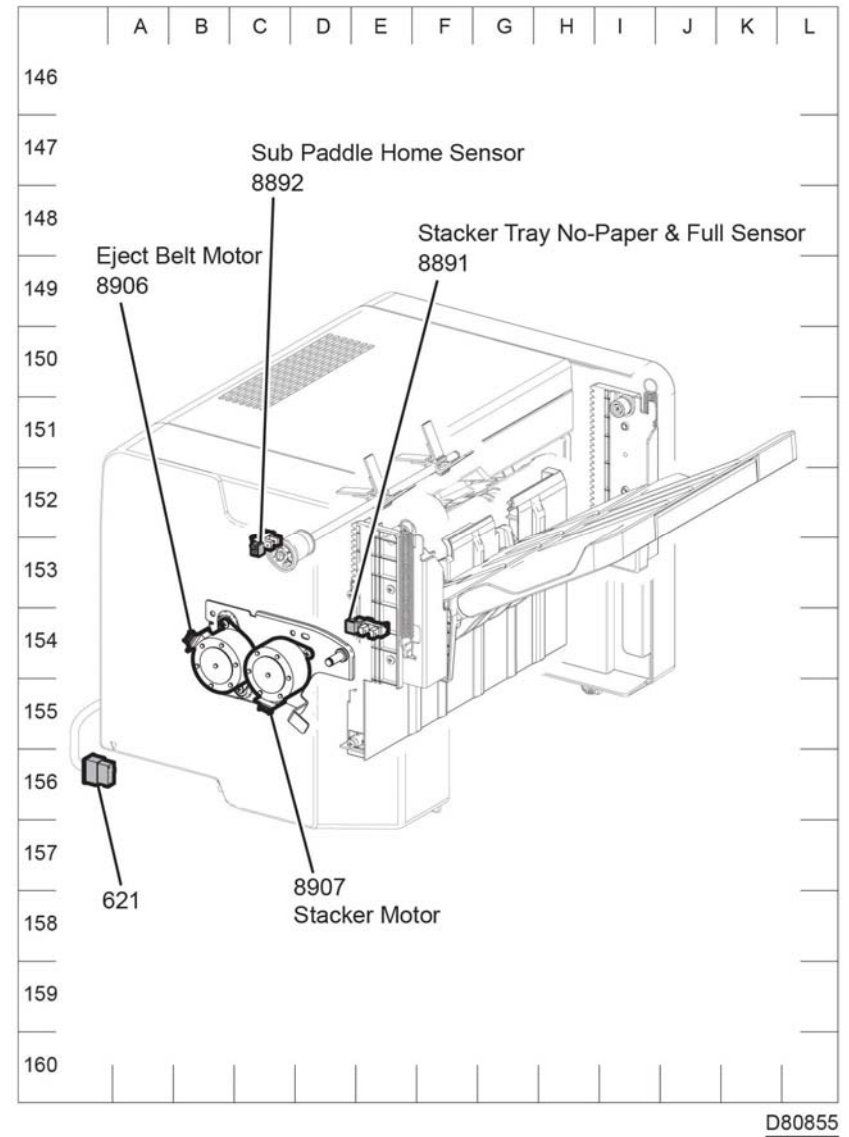
Figure 2 Connector locations, sensors and motors (1/4)

P/J8907	Figure 2	C-156	Connects harness assembly FIN MOT and stacker MOT
P/J8908	Figure 3	C-157	Connects harness assembly stapler M and stapler assembly
P/J8909	Figure 3	B-153	Connects harness assembly FIN IL and switch safety L
P/J8910	Figure 3	D-152	Connects harness assembly FIN TRANS M1 and motor assembly
P/J8912	Figure 4	H-154	Connects harness assembly compile tamper MOT, clutch and set clump clutch
P/J8913	Figure 3	I-151	Connects harness assembly FIN SNR1 and harness assembly FIN compile sensor
P/J8914	Figure 3	I-150	Connects harness assembly FIN MOT and harness assembly FIN TRANS M1
P/J8935	Figure 3	I-151	Rear Cover Interlock Sensor

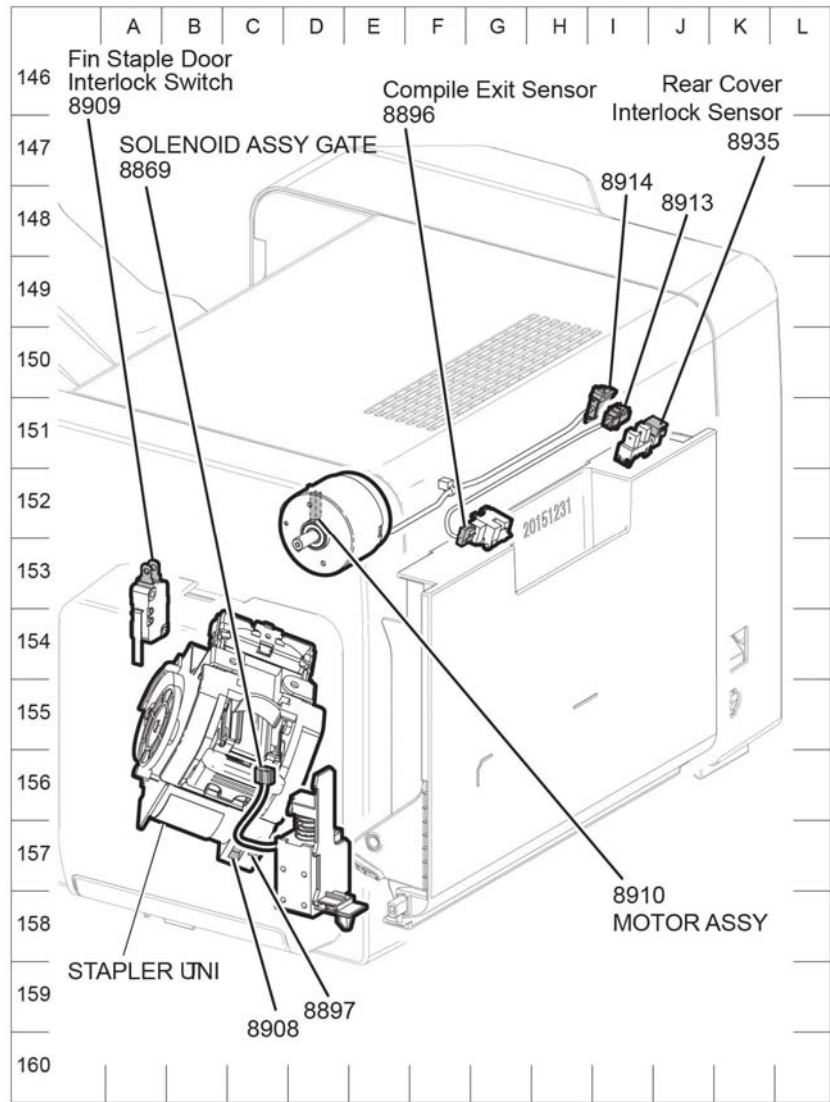
D80856

Figure 3 Connector locations, sensors and motors (2/4)
