# VersaLink® B600/B610 Printer and B605/B615 Multifunction Printer Service Manual

Xerox® VersaLink® B600 Family MFP Service Manual

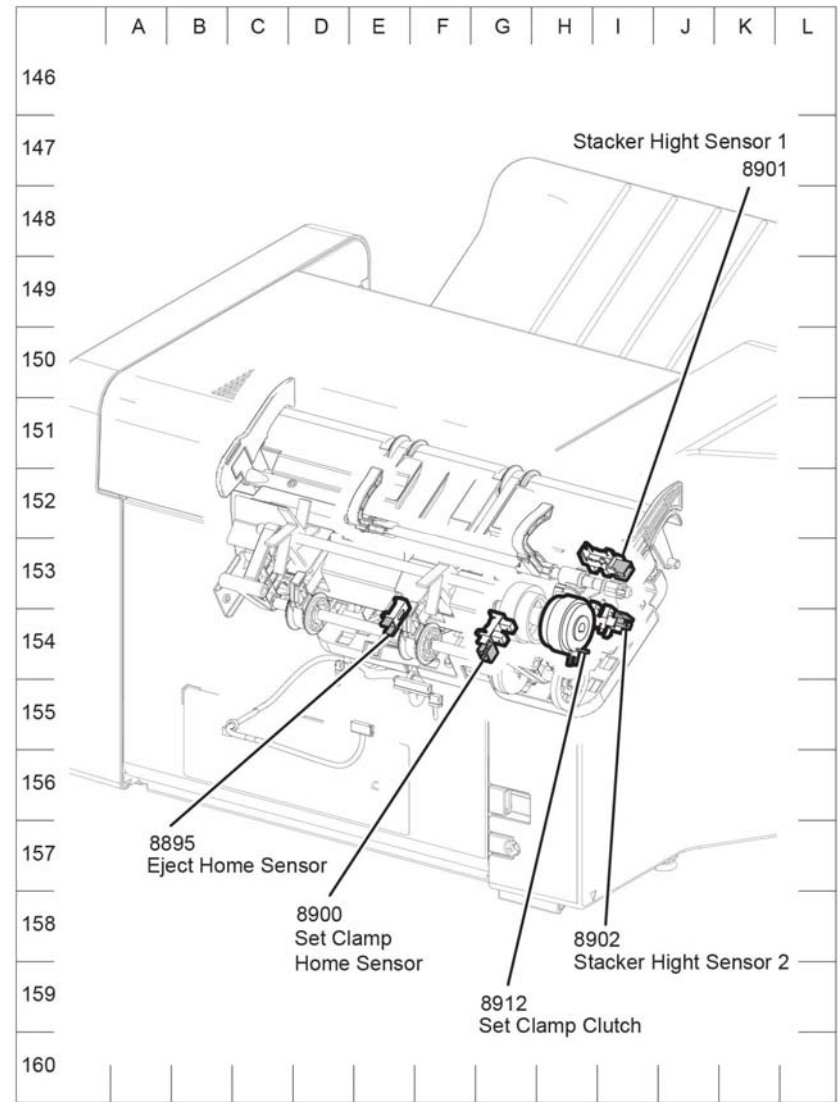
D80857

Figure 4 Connector locations, sensors and motors (3/4)

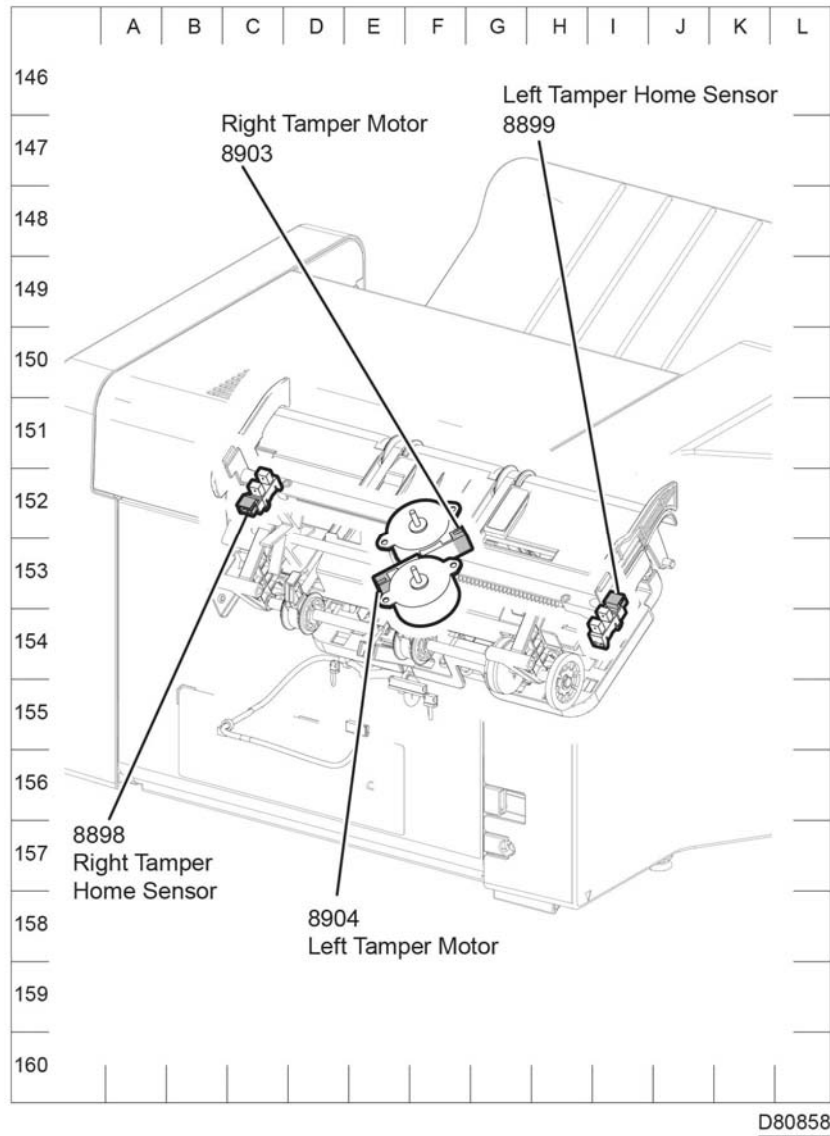
Figure 5 Connector locations sensors and motors (4/4)

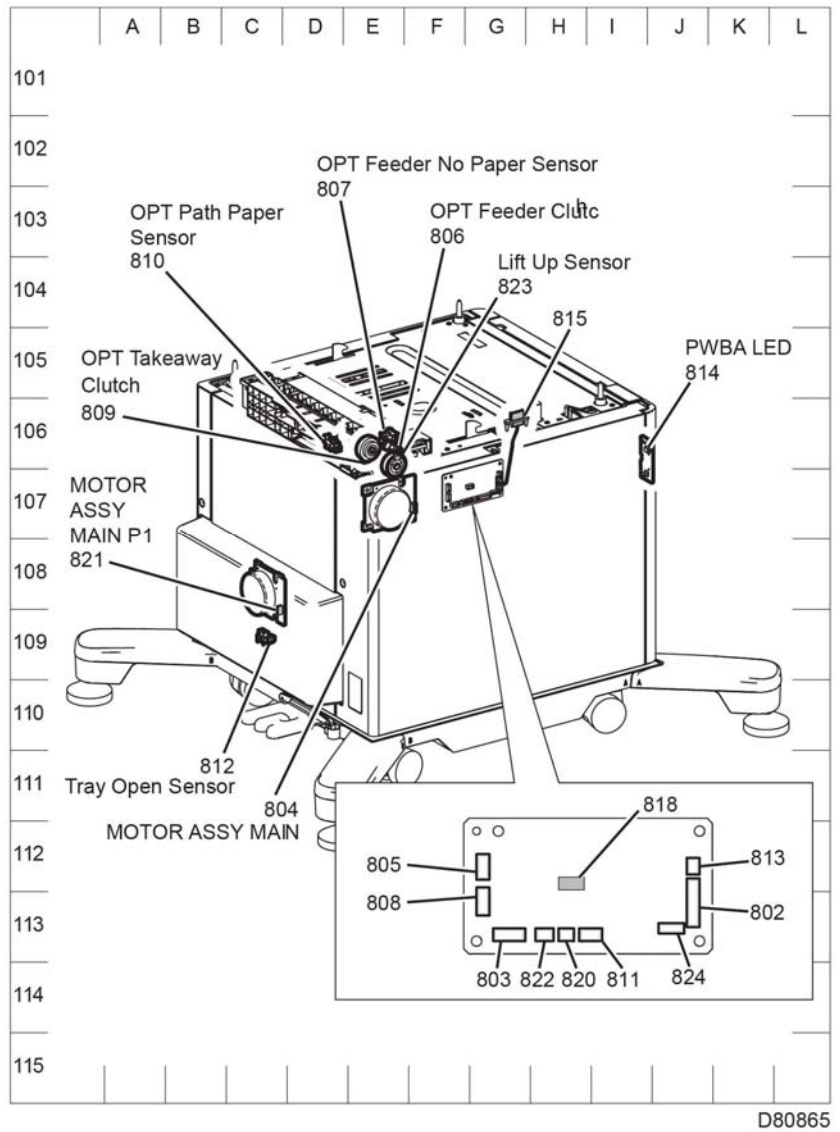
Figure 1 HCF P/J locations

P/J814	Figure 1	I-107	Connects Tray LED assembly and harness assembly OPF LED
P/J815	Figure 1	G-106	Connects PWBA assembly OPF 550 and harness assembly FDR Drawer 2
P/J818	Figure 1	H-112	Connects harness assembly OPF2-C and harness assembly FDR Drawer 2
P/J820	Figure 1	H-114	Connects PWBA OPF and harness assembly lift motor I/L
P/J821	Figure 1	C-108	Connects harness assembly T-Open/Lift motor and main motor assembly P1
P/J822	Figure 1	H-113	Connects PWBA OPF and harness assembly lift up sensor
P/J823	Figure 1	F-107	Connects harness assembly lift up sensor and lift up sensor
P/J824	Figure 1	J-113	Connects PWBA OPF and rear cover interlock switch

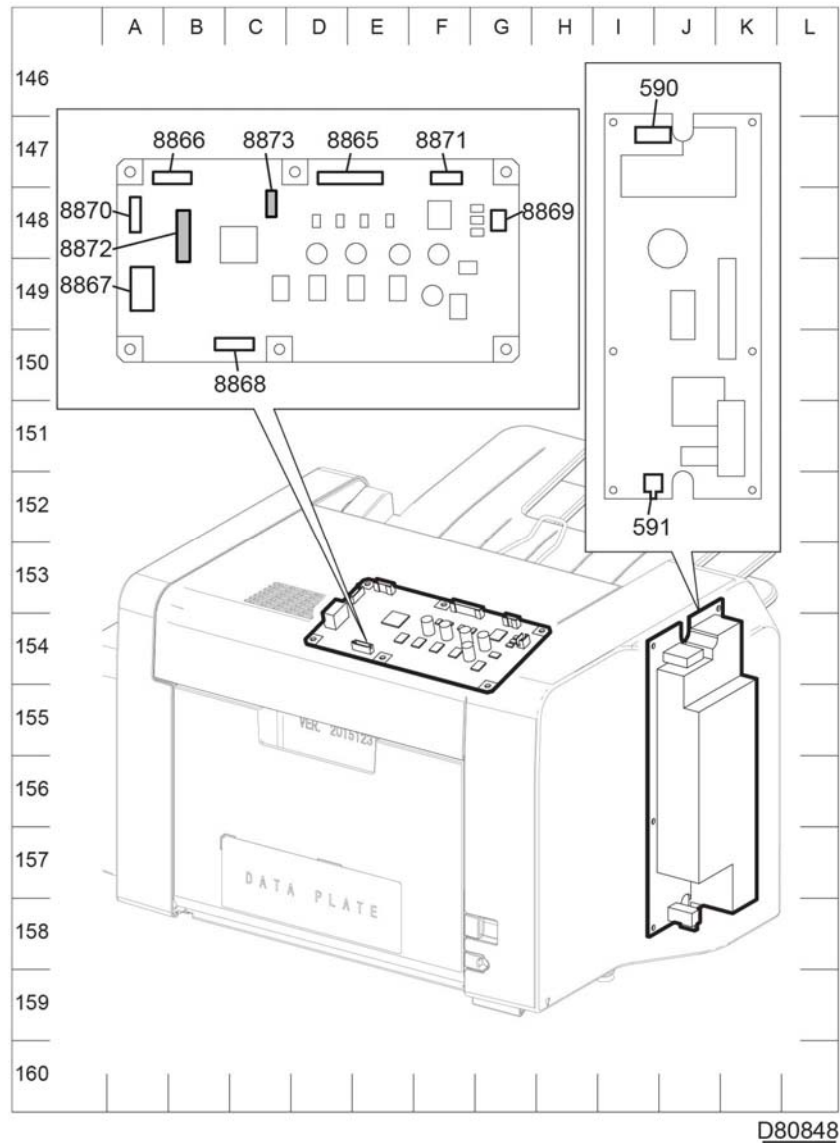
Figure 1 IOT P/J layout diagram

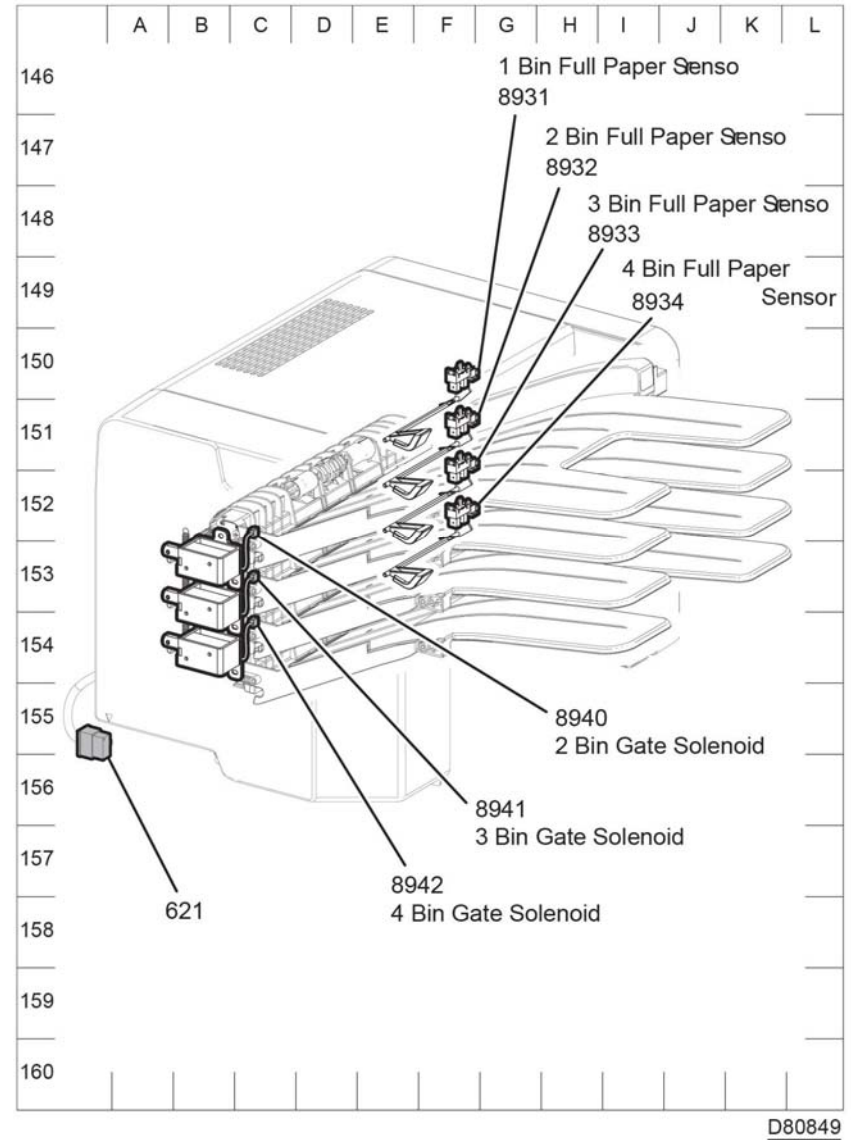
Figure 2 Connector locations (1/2)

P/J	Maps	Coordinates	Description
P/J8942	Figure 2	C-154	Connects harness assembly TRANS S and bin-4 gate solenoid
P/J8943	Figure 3	J-155	Connects harness assembly vertical LED and harness assembly vertical sensor

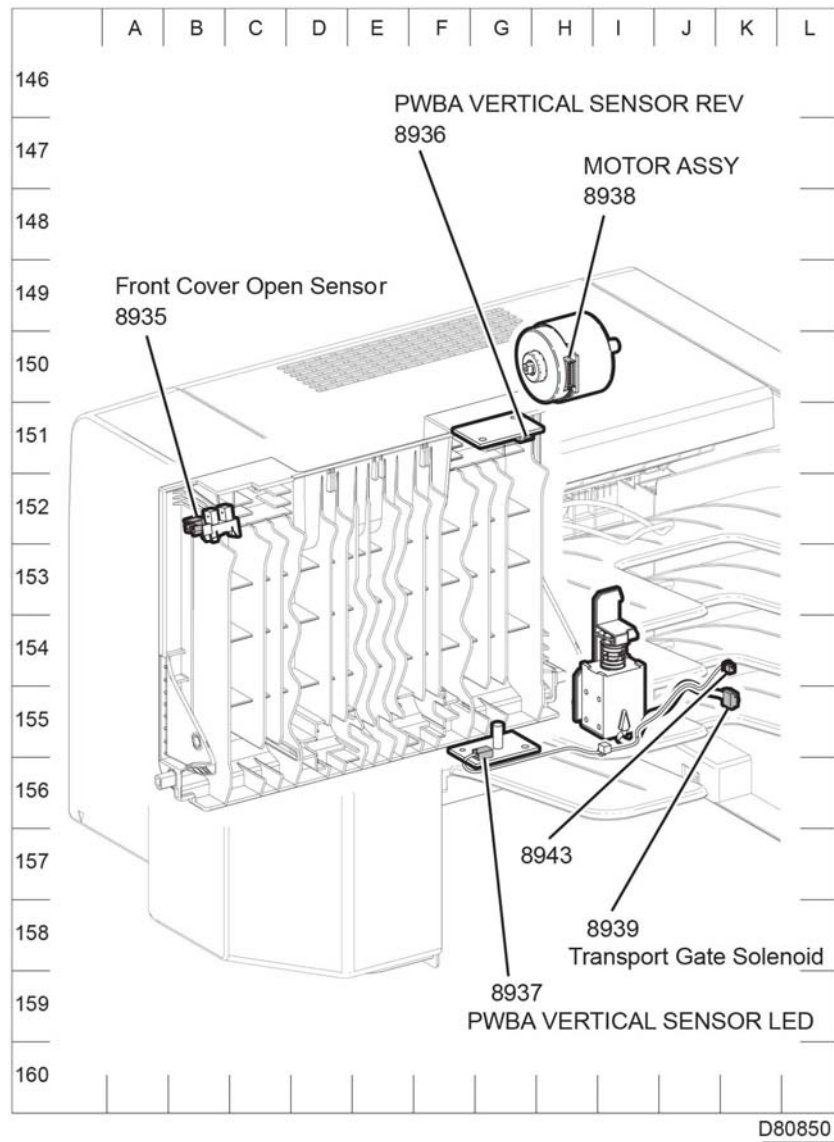
Figure 3 Connector locations (2/2)

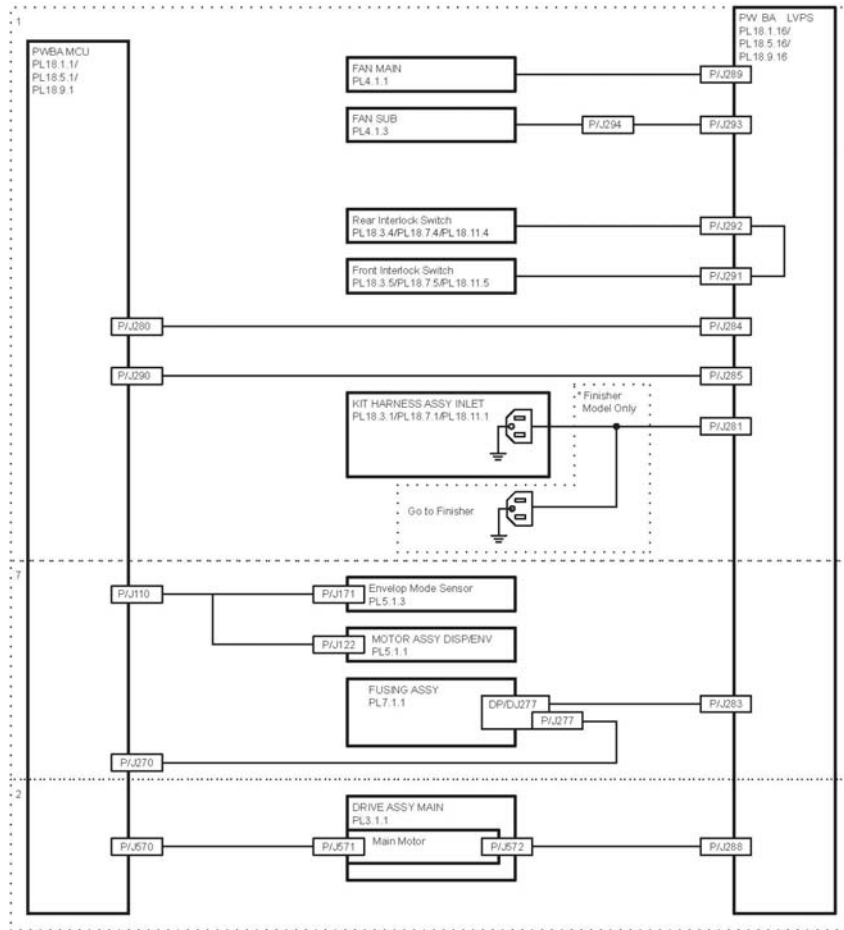
E-8-0683-A

Figure 1 MCU control system wiring diagram

Figure	System and Connections
Figure 1	MCU Control
Figure 2	Power Supply
Figure 3	Optional Feeder
Figure 4	ESS Control
Figure 5	Accessories

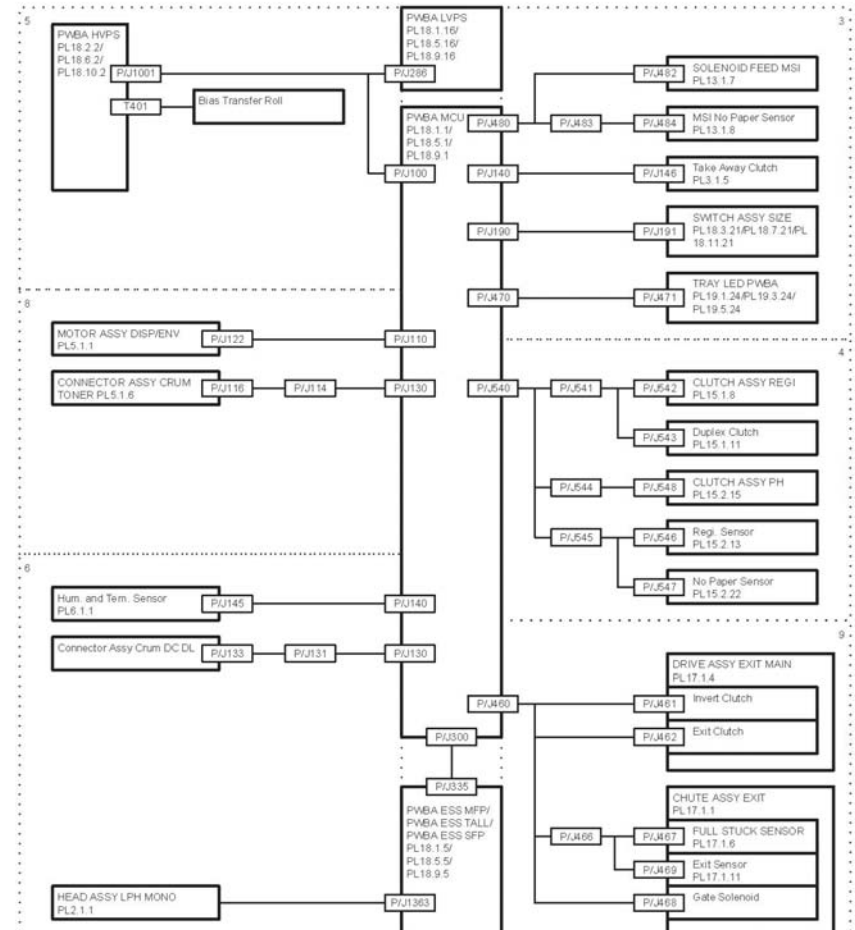
E-8-0684-A

Figure 2 Power supplies system wiring diagram 2

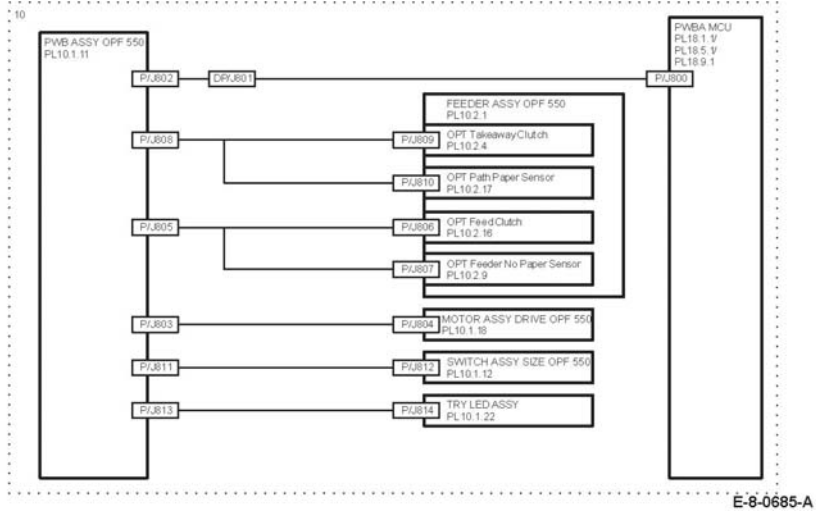
Figure 3 Optional feeder system wiring diagram

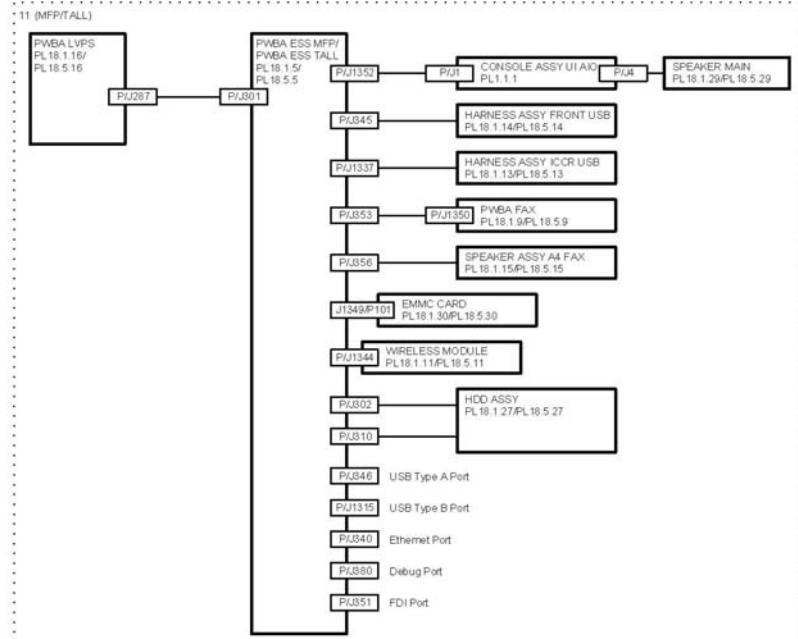
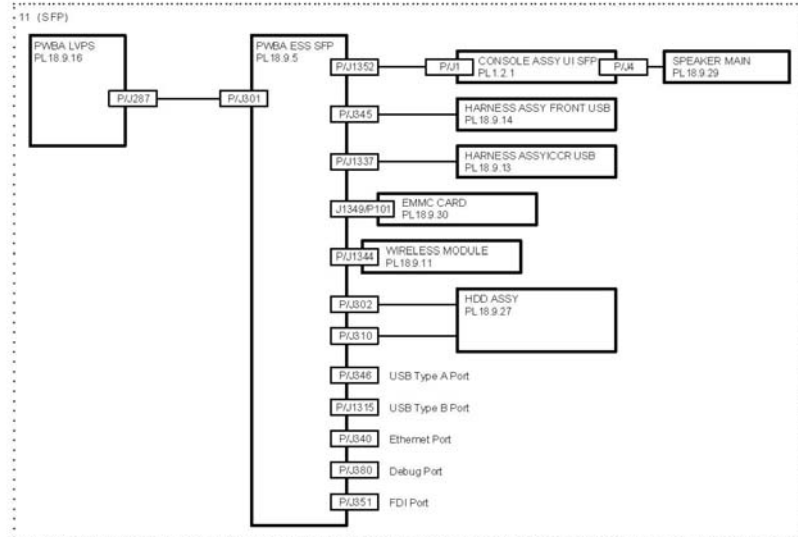
E-8-0688-A

Figure 4 ESS Control system wiring diagram

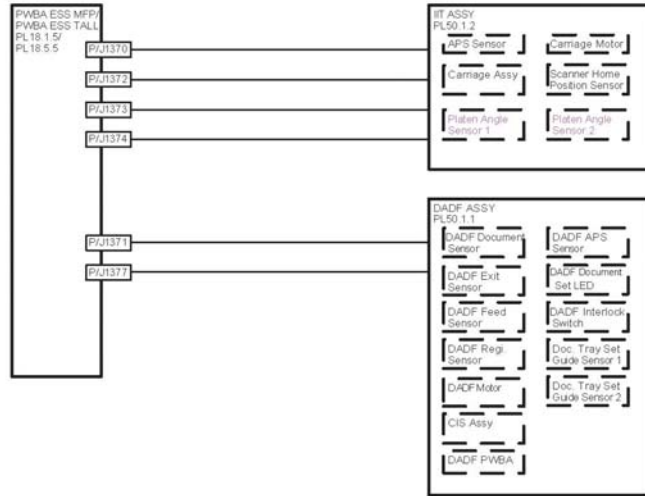
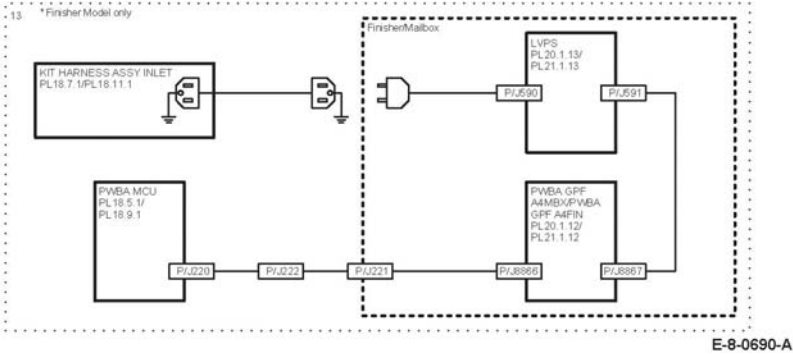
E-8-0690-A

Figure 5 Accessories

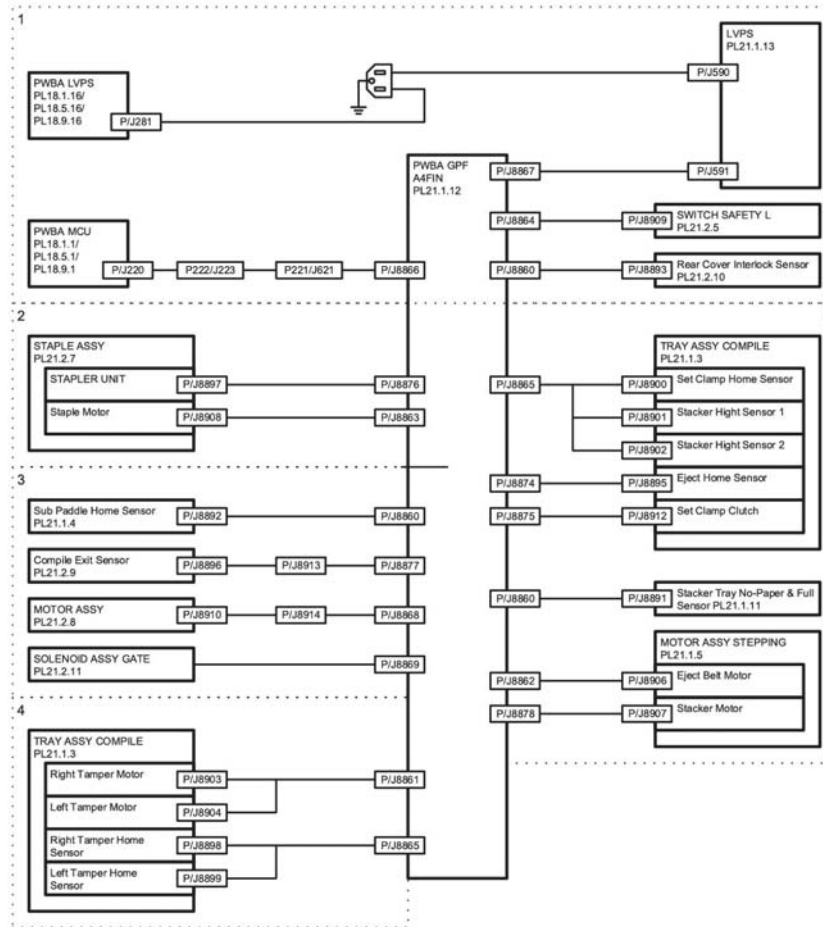
D80859

Figure 2 System diagram

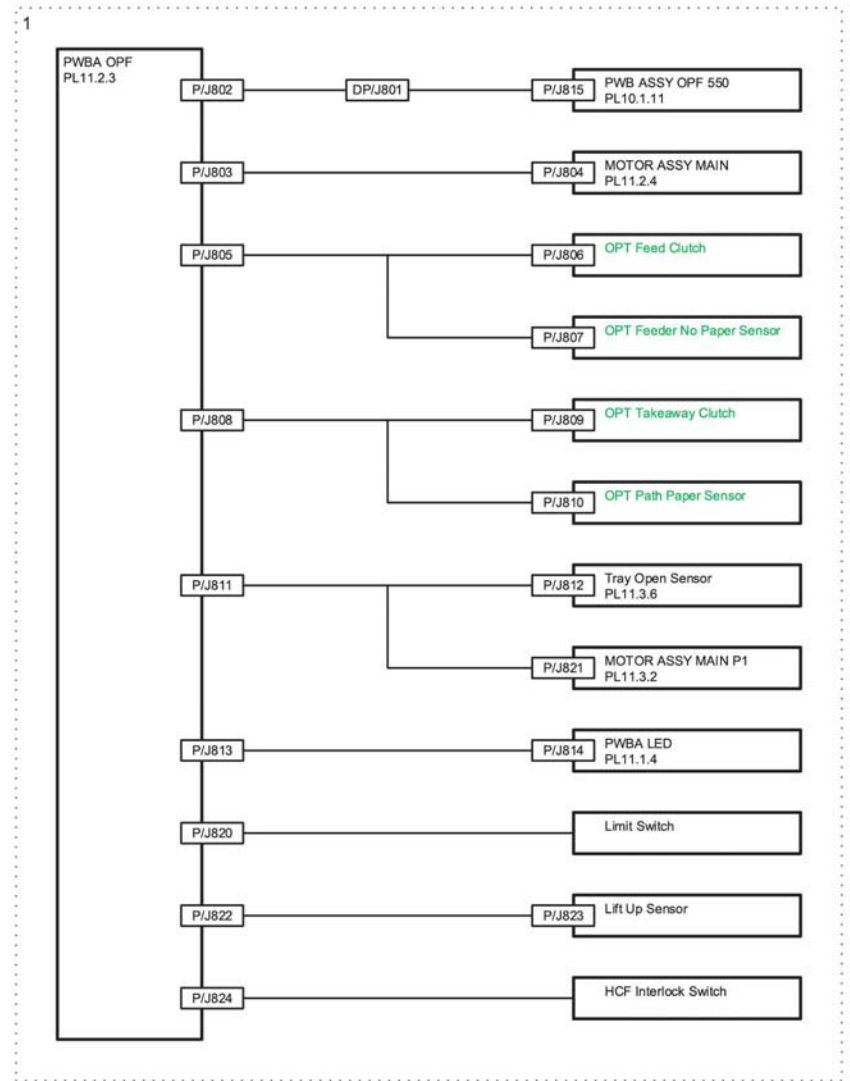
D80866

Figure 2 HCF system diagram

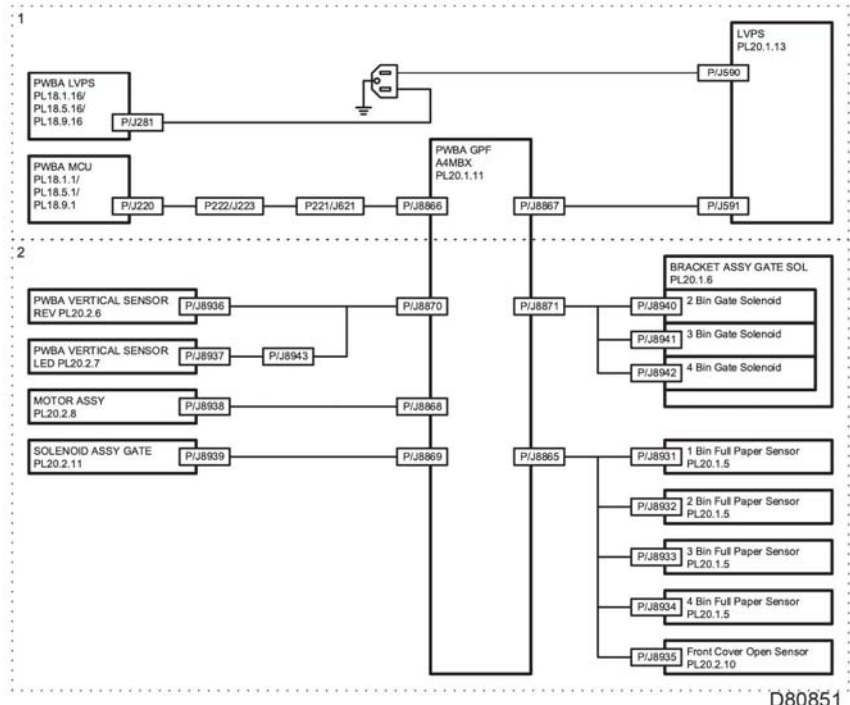
D80851

Figure 2 System diagram

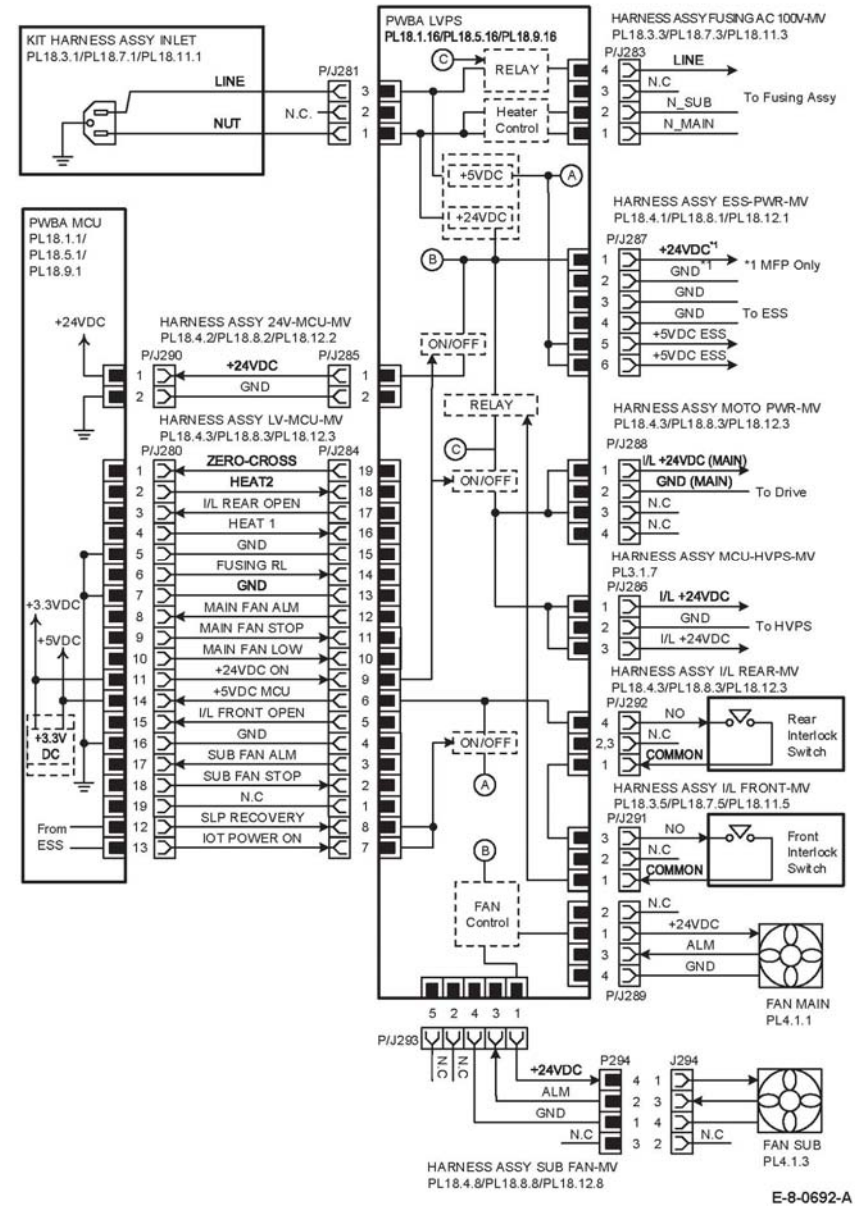
Figure 1 Power connection diagram

- Each output (+24VDC, +5VDC) of LVPS stops all outputs if there is overvoltage.
- The operating voltage of the overvoltage protection of each output is as following:
  - +24VDC: 27 VDC~36 VDC
  - +5VDC: 7 VDC

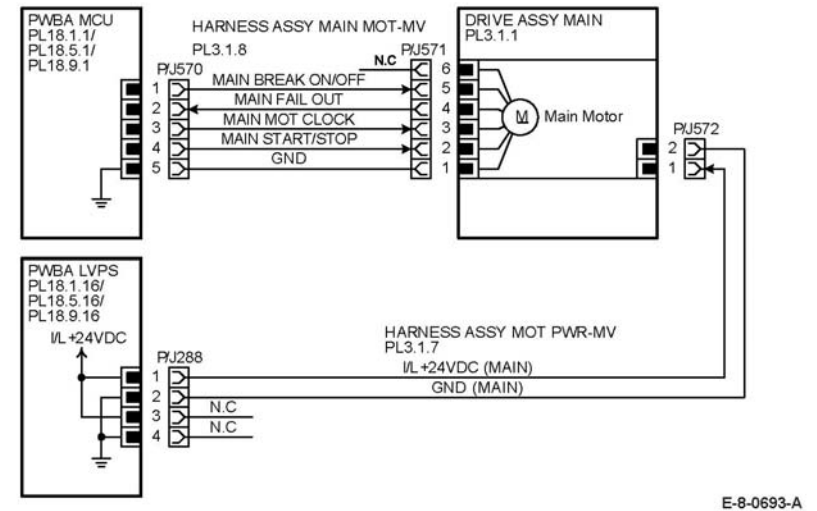
Figure 2 Drive connection diagram

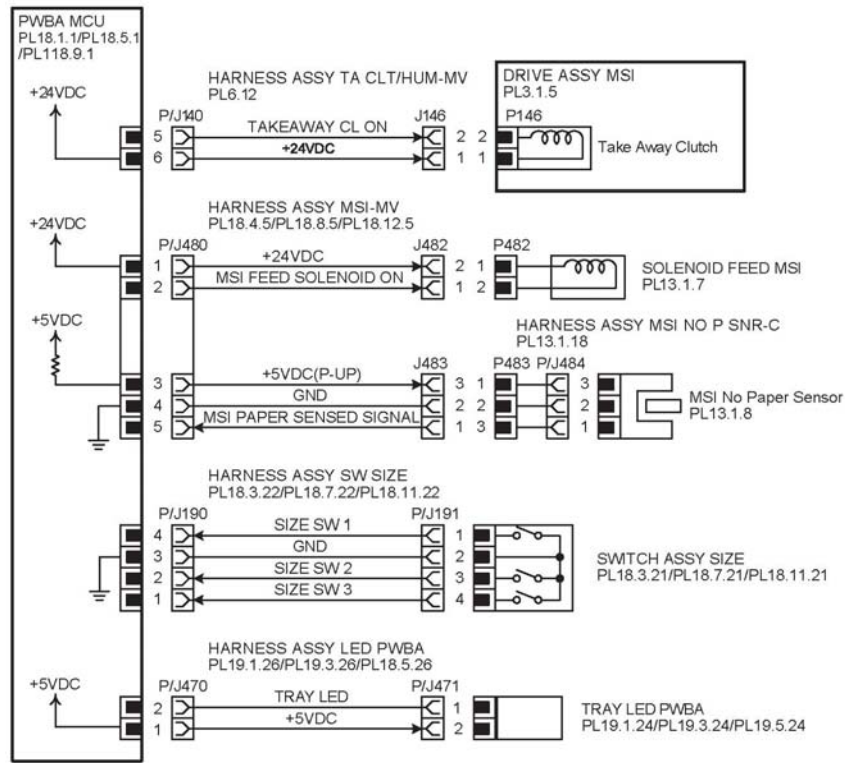
Figure 3 Bypass Tray (MSI) connection diagram

### Bypass Tray (MSI) connection diagram

Printer Subsystem	Diagram
Power connection diagram	<a href="#">Figure 1</a>
Drive connection diagram	<a href="#">Figure 2</a>
Bypass tray (MSI) connection diagram	<a href="#">Figure 3</a>
Paper transfer connection diagram	<a href="#">Figure 4</a>
HVPS connection diagram	<a href="#">Figure 5</a>
Xerographic connection diagram	<a href="#">Figure 6</a>
Fuser connection diagram	<a href="#">Figure 7</a>
Developer connection diagram	<a href="#">Figure 8</a>
Exit connection diagram	<a href="#">Figure 9</a>
Optional 550 feeder connection diagram	<a href="#">Figure 10</a>
Controller connection diagram (MFP)	<a href="#">Figure 11</a>
Controller connection diagram (SFP)	<a href="#">Figure 12</a>
Scanner connection diagram	<a href="#">Figure 13</a>
Finisher mailbox connection diagram	<a href="#">Figure 14</a>

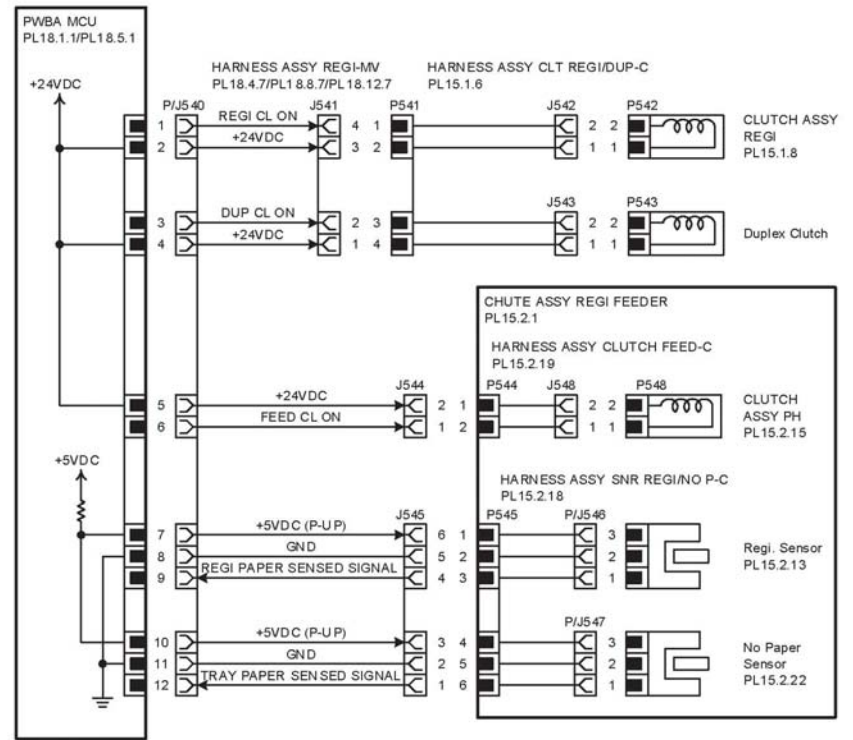
Figure 4 Paper Transfer connection diagram

### Paper Transfer connection diagram

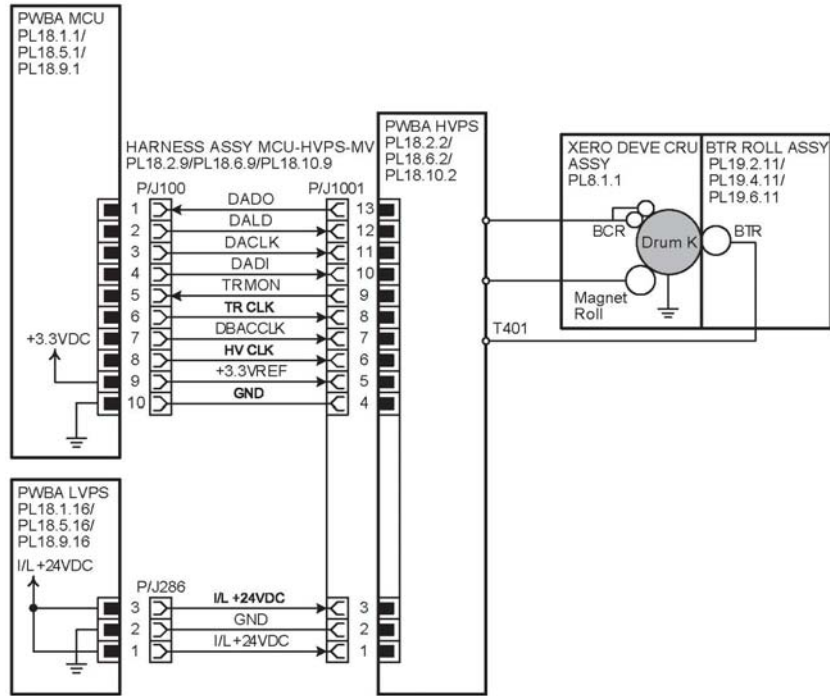
Figure 5 HVPS connection diagram

### HVPS connection diagram

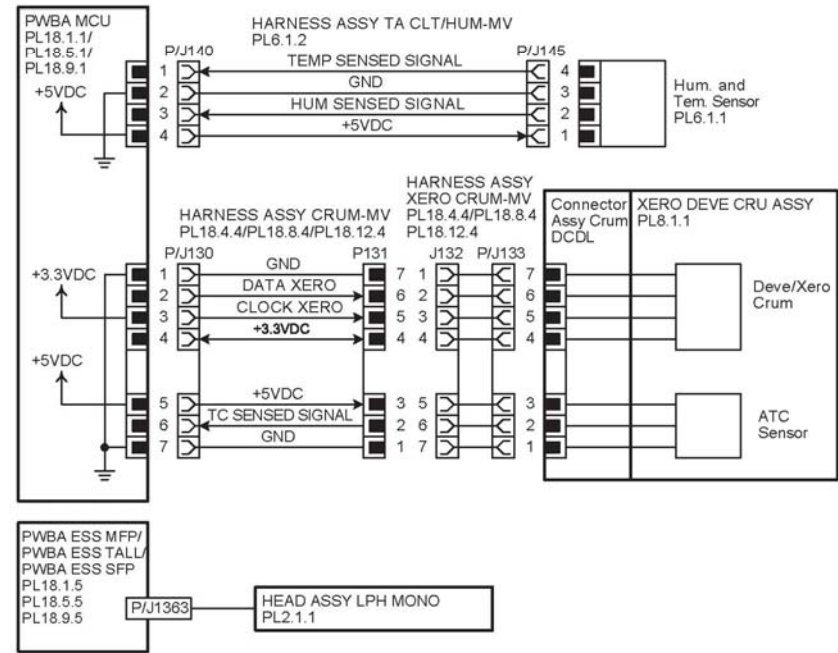
Figure 6 Xerographic connection diagram

### Xerographic connection diagram

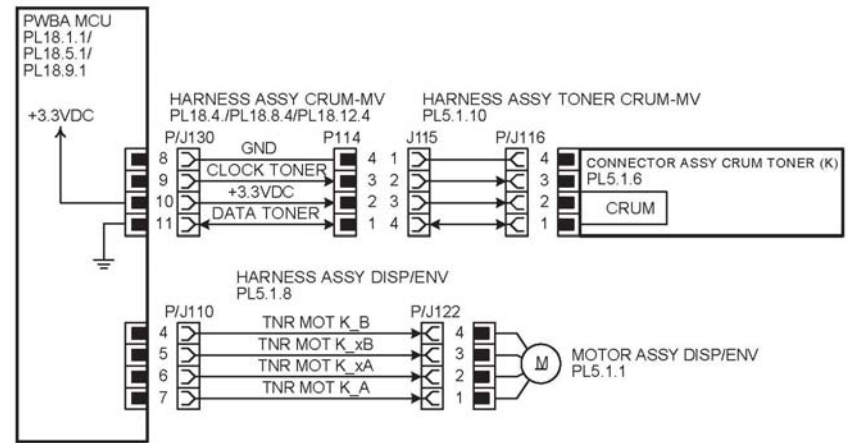
Figure 8 Developer connection diagram

## Developer connection diagram

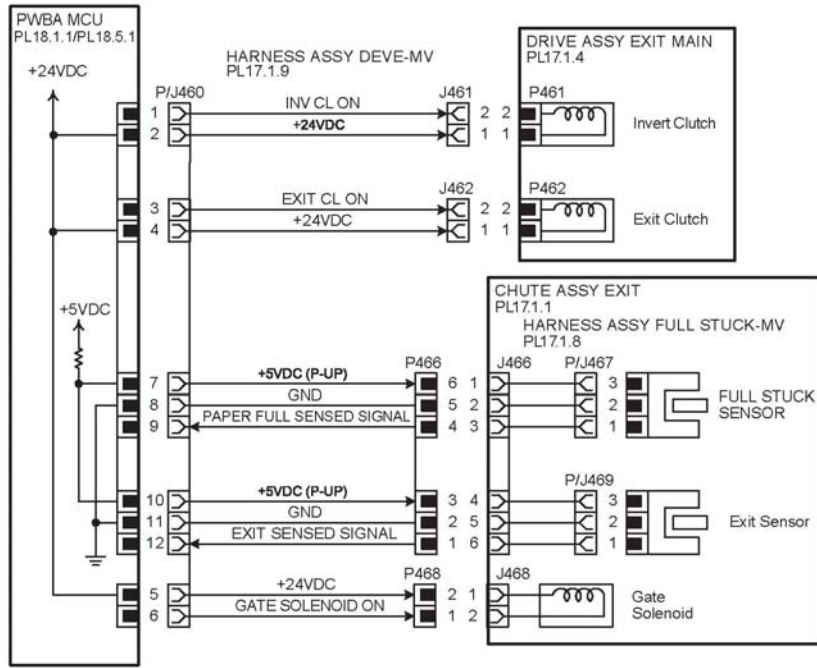
Figure 9 Exit connection diagram

## Exit connection diagram

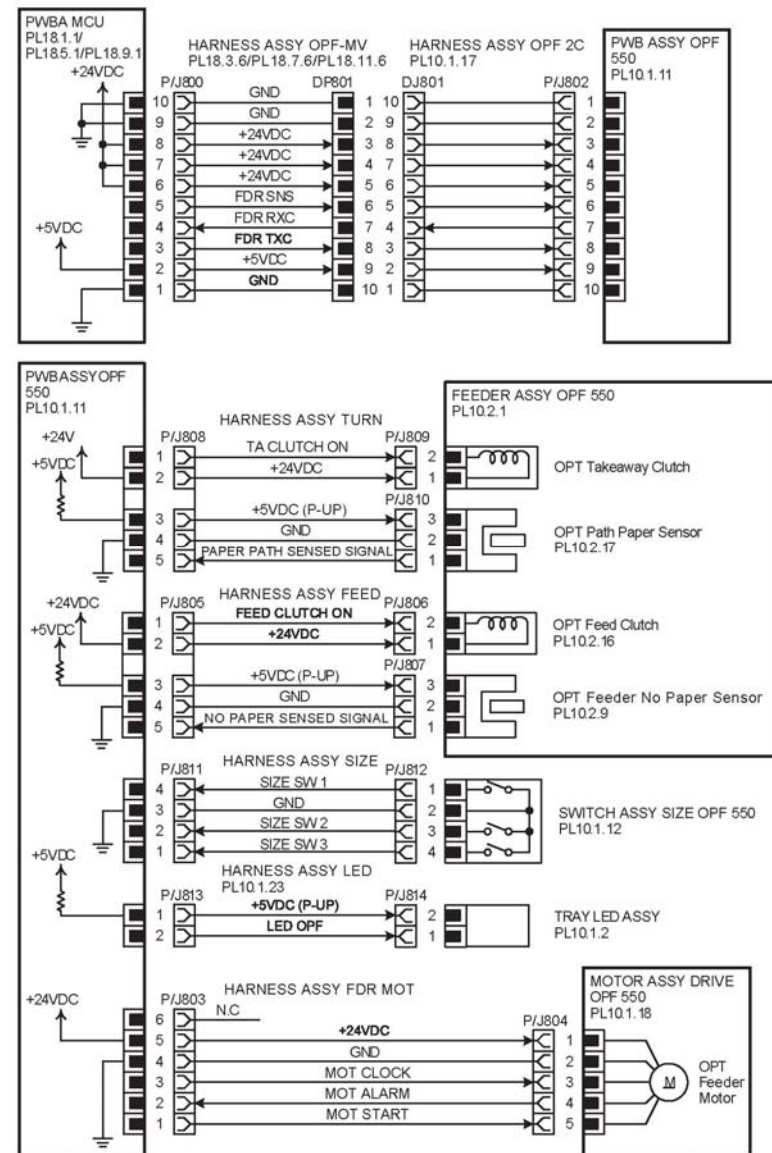
Figure 10 Optional 550 feeder connection diagram

## 550 Option Feeder connection diagram

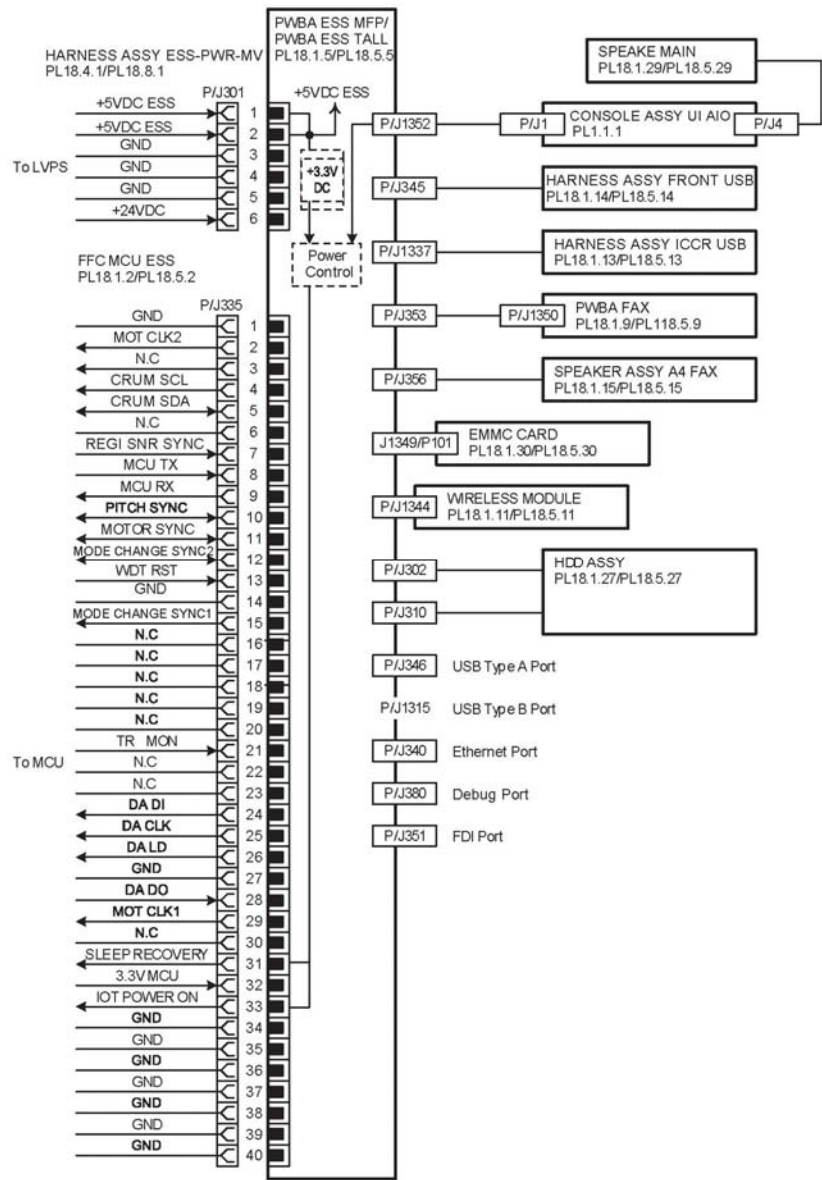
Figure 11 Controller connection diagram (MFP)

# Controller connection diagram (MFP and SFP)

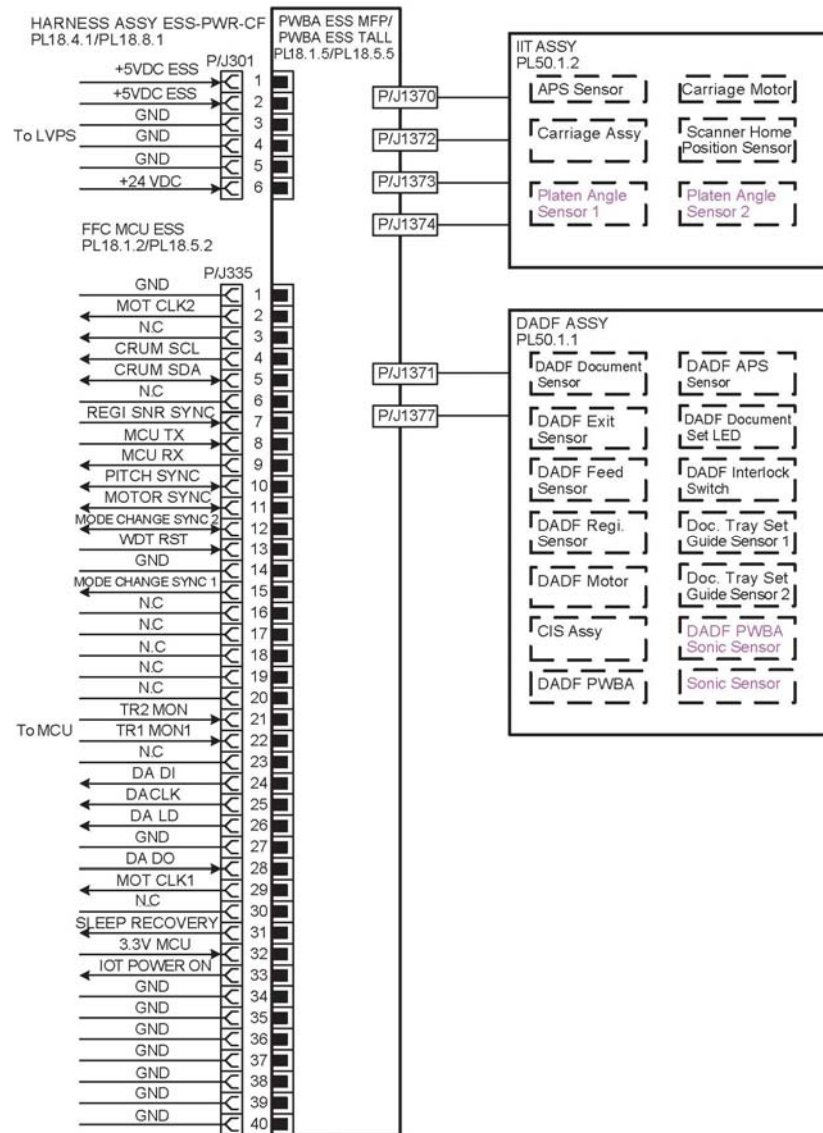
Figure 13 Scanner connection diagram

## Scanner connection diagram

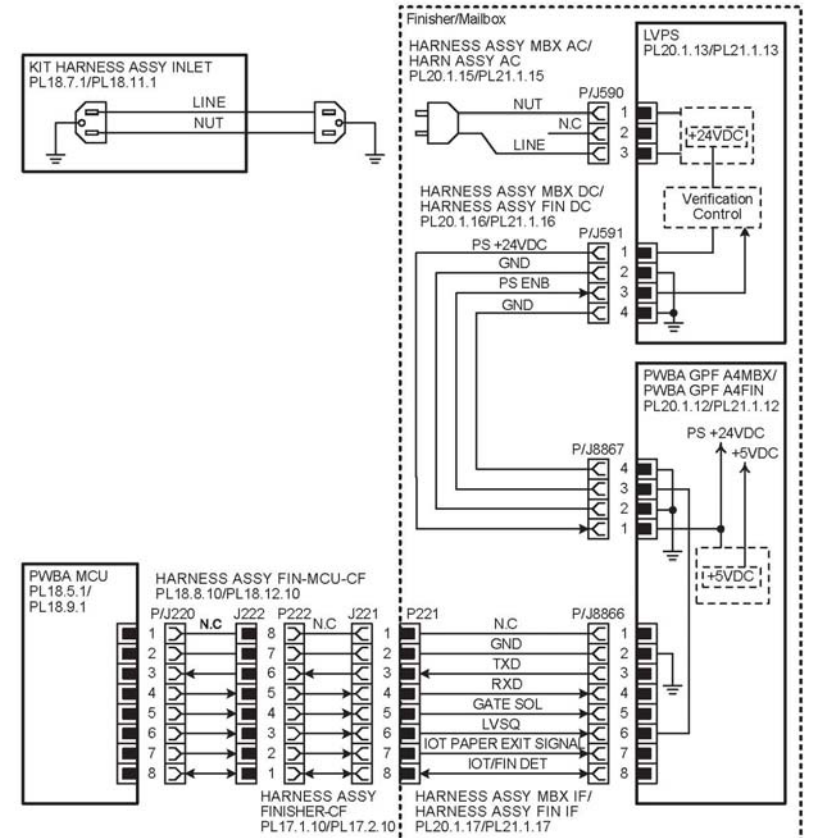
Figure 14 Finisher and mailbox connection diagram

## Finisher and Mailbox connection diagram

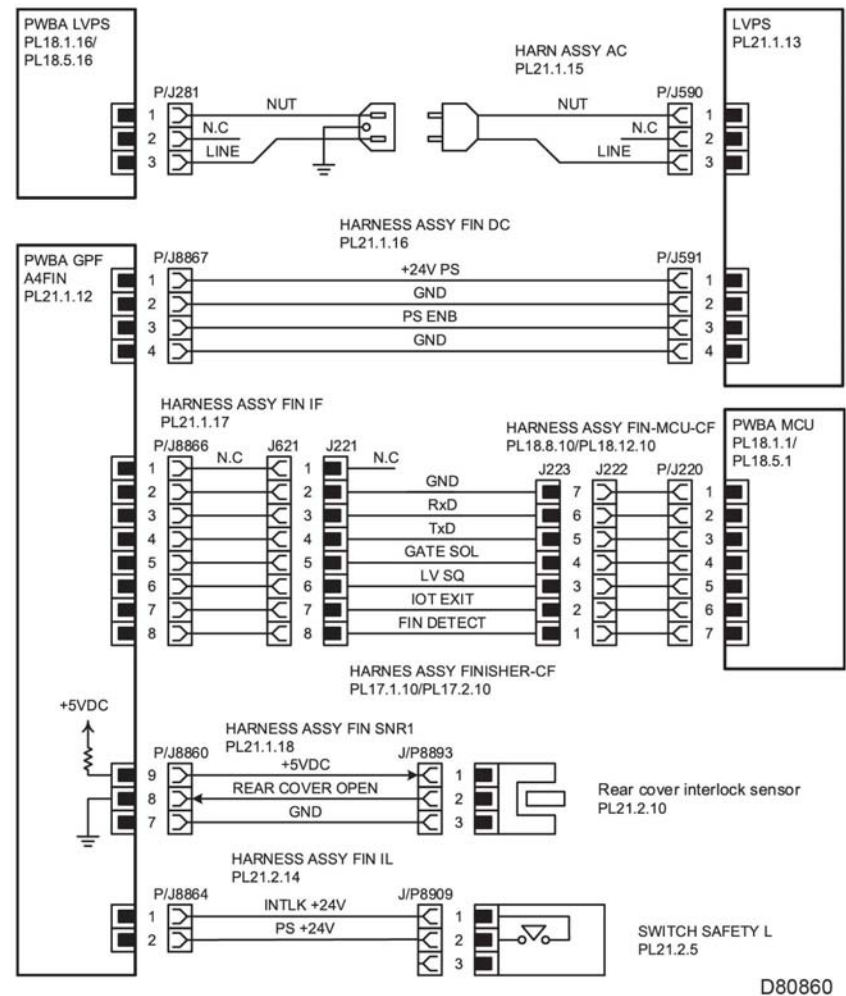
**Figure 2 Power connection diagram**

LVPS over current protection circuit

- 24VDC: 27VDC~36VDC
- 5VDC: 7VDC

Finisher Subsystem	Diagram
Power connection diagram	<a href="#">Figure 2</a>
Stapler connection diagram	<a href="#">Figure 3</a>
Paper Transport connection diagram	<a href="#">Figure 4</a>
Tamper connection diagram	<a href="#">Figure 5</a>
Ejector/stacker connection diagram	<a href="#">Figure 6</a>

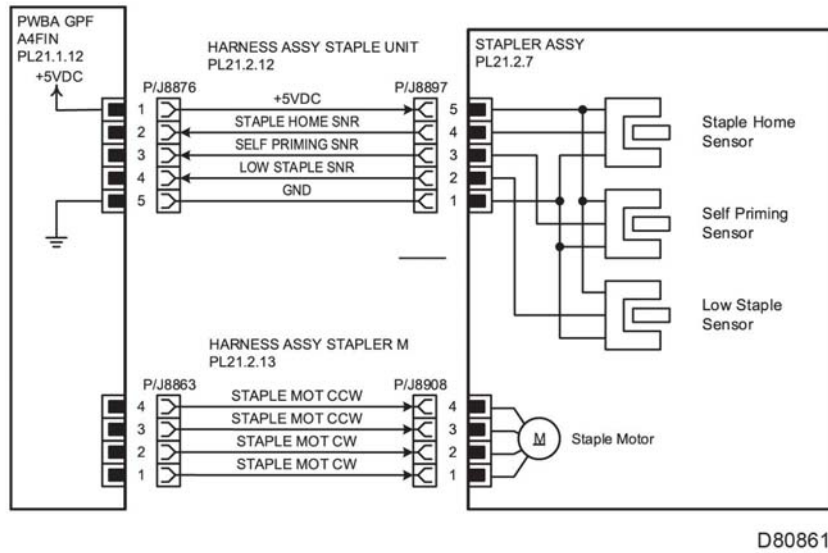
Figure 3 Stapler connection diagram

**Finisher Stapler**

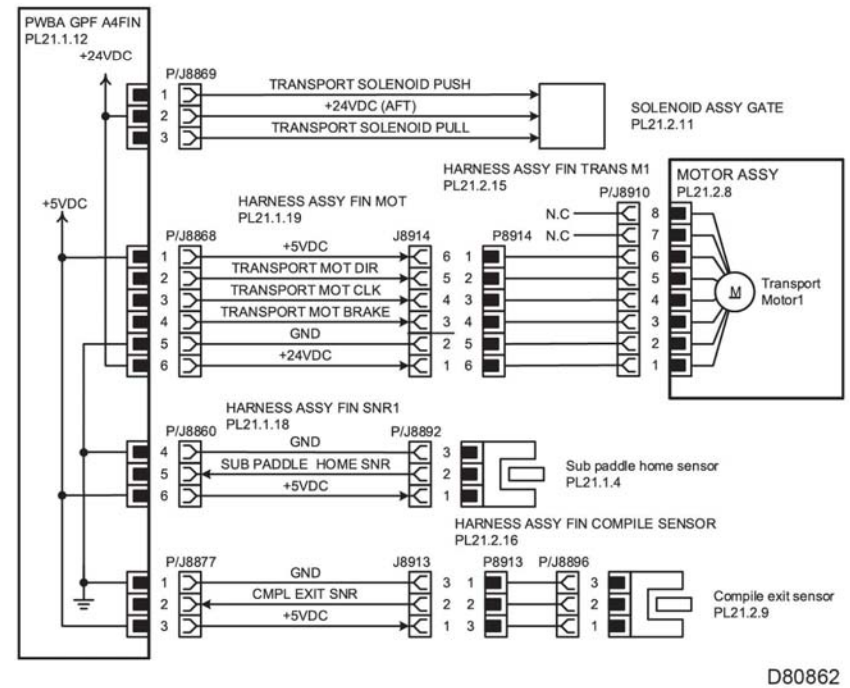
Figure 4 Paper Transport connection diagram

**Finisher Paper Transport**
