# VersaLink® B600/B610 Printer and B605/B615 Multifunction Printer Service Manual

Xerox® VersaLink® B600 Family MFP Service Manual

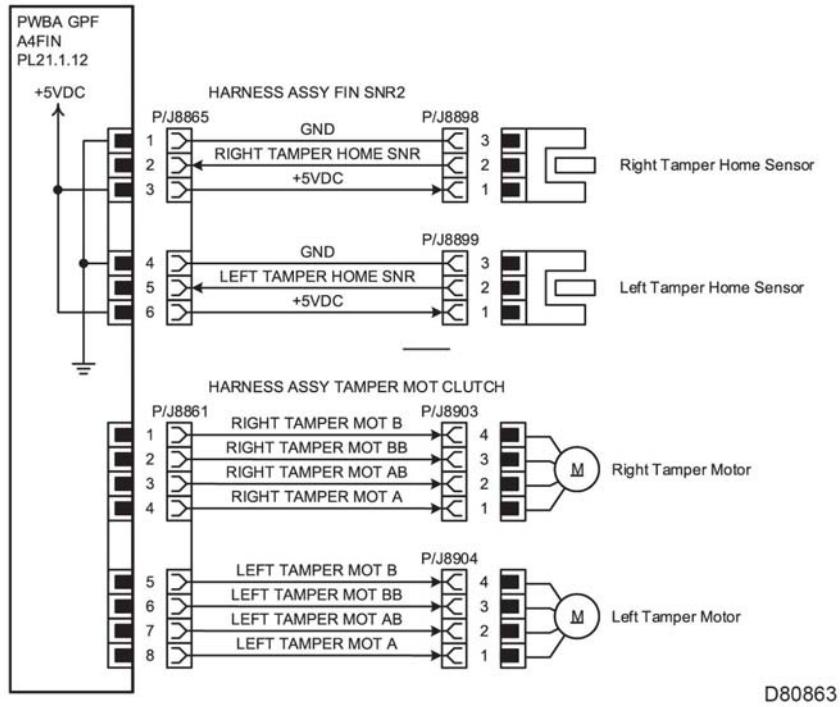
Figure 5 Tamper connection diagram

Finisher Tamper

Finisher Subsystem	Diagram
Power connection diagram	<a href="#">Figure 2</a>
Stapler connection diagram	<a href="#">Figure 3</a>
Paper Transport connection diagram	<a href="#">Figure 4</a>
Tamper connection diagram	<a href="#">Figure 5</a>
Ejector/stacker connection diagram	<a href="#">Figure 6</a>

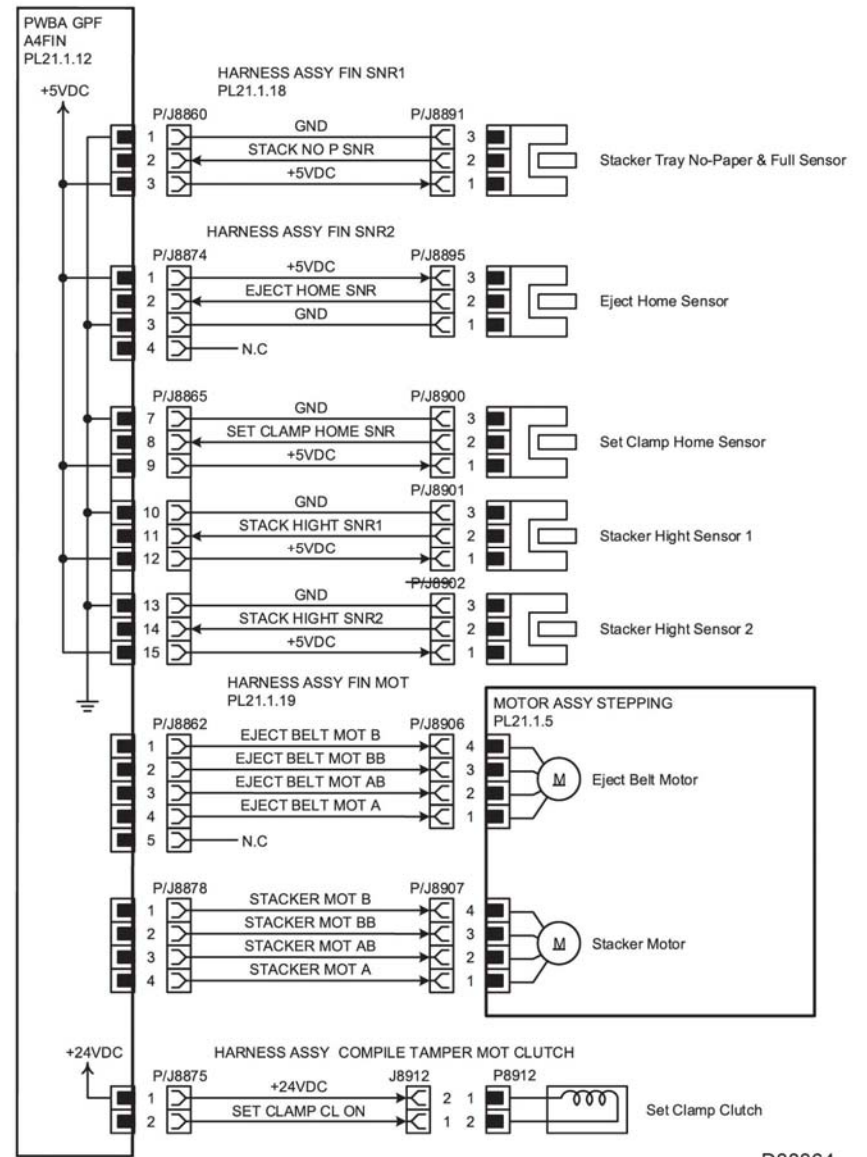
Figure 6 Ejector/stacker connection diagram

Finisher Ejector/Stacker

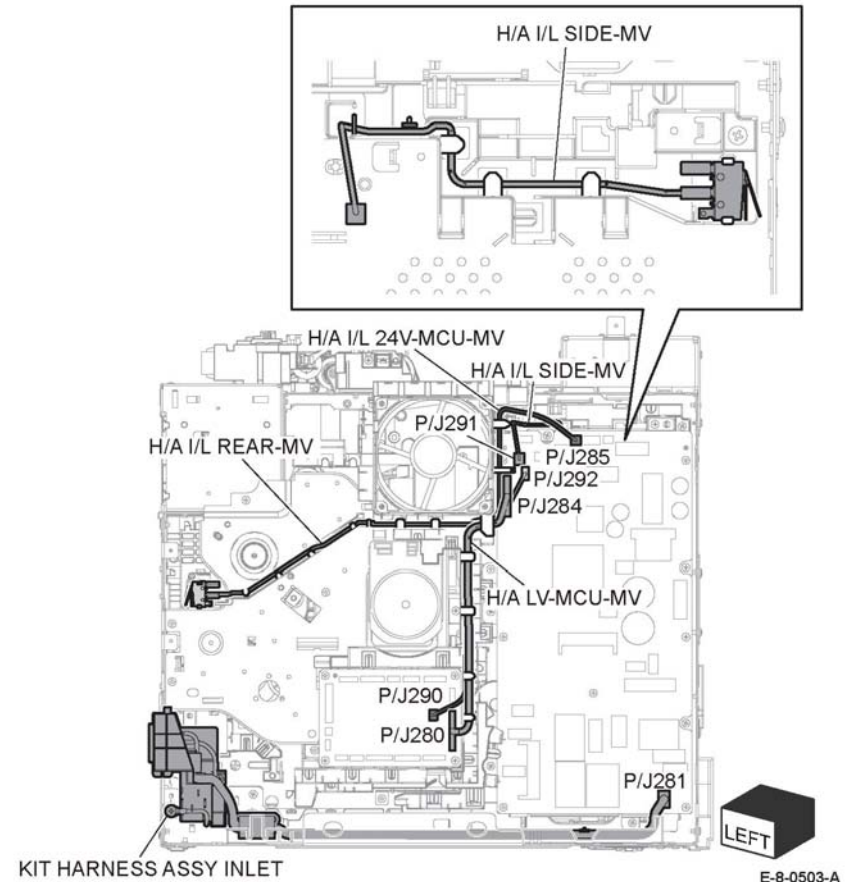
**Figure 1 Inlet, I/L rear MV, I/L side MV, 24V MCU MV, LV MCU MV**

Diagram	Description
Figure 1	Inlet, I/L rear MV, I/L side MV, 24V MCU MV, LV MCU MV
Figure 2	LED, sub fan-MV
Figure 3	Main motor-MV, Motor power-MV
Figure 4	MSI-MV (Bypass tray), MSI no paper sensor, OPF-MV, size switch
Figure 5	Registration/Duplex Clutch, Feed Clutch, Registration-MV, Registration Sensor, no paper sensor.
Figure 6	BTR, MCU HVPS-MV
Figure 7	CRUM-MV, xerographic CRUM-MV
Figure 8	Take away clutch, Humidity-MV
Figure 9	Fusing AC, Fusing DC-MV
Figure 10	Dispenser, Environmental-MV, CRUM-MV
Figure 11	Finisher-MV, finisher MCU-MV, developer-MV, full stack-MV
Figure 12	UI, FFC MCU ESS, fax, ICCR USB, front USB, ESS power-MV, DADF/IIT, FCC LPH (MFP std)
Figure 13	Speaker assembly A4 fax, Main Speaker (MFP std)
Figure 14	UI, FFC MCU ESS, fax, ICCR USB, front USB, ESS power-MV, DADF/IIT, FCC LPH (MFP-tall)
Figure 15	Speaker assembly A4 fax, Main Speaker (MFP tall)
Figure 16	UI, FFC MCU ESS, front USB, ESS Power-MV, FFC LPH (SFP)

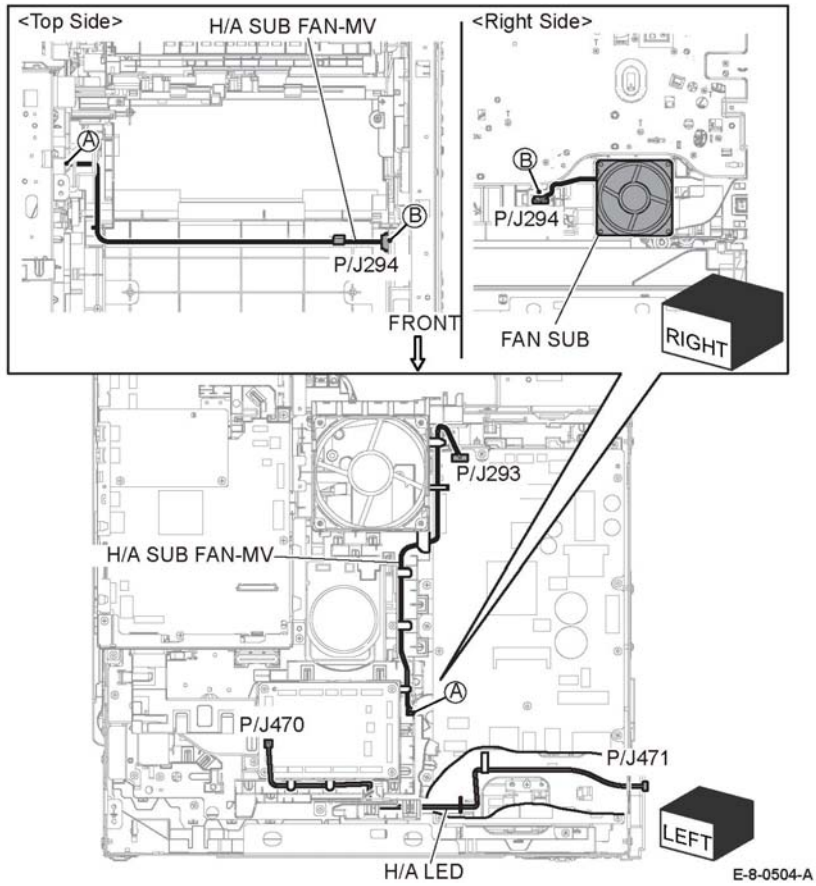
Figure 2 LED, sub fan\_MV

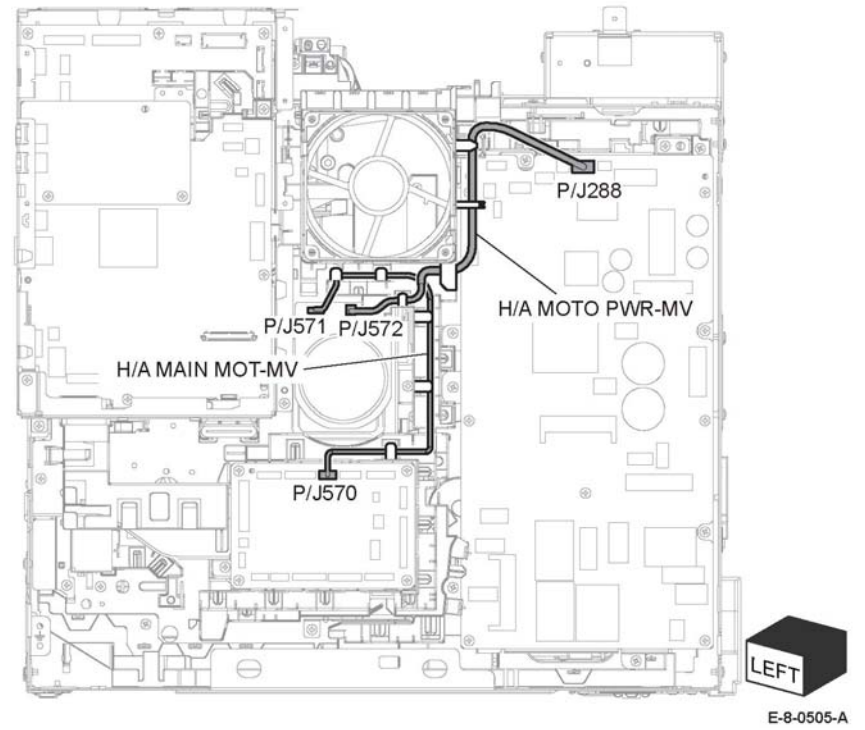
Figure 3 Motor power-MV, Main motor

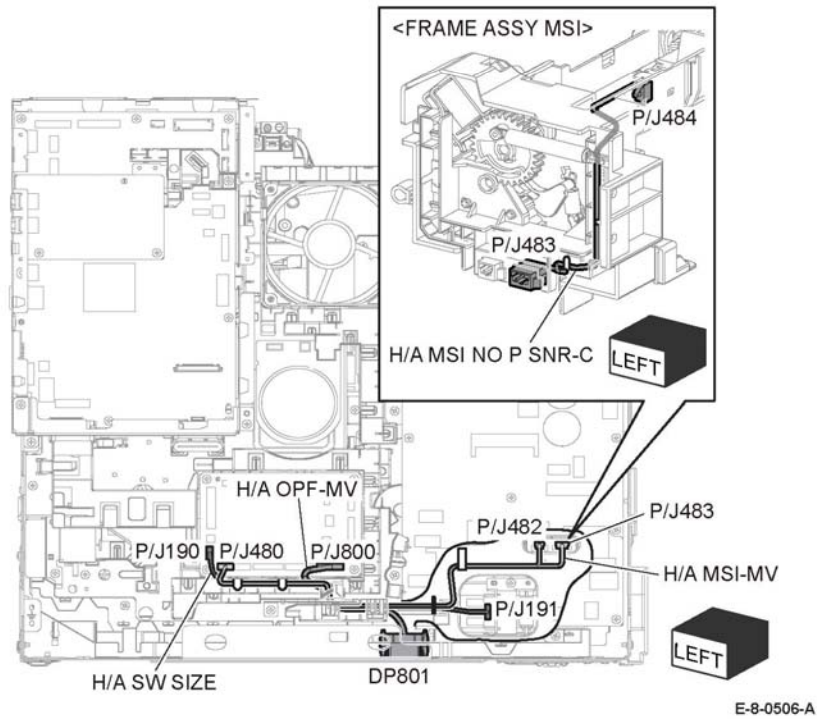
Figure 4 MSI-MV (Bypass tray), MSI no paper sensor, OPF-MV, size switch

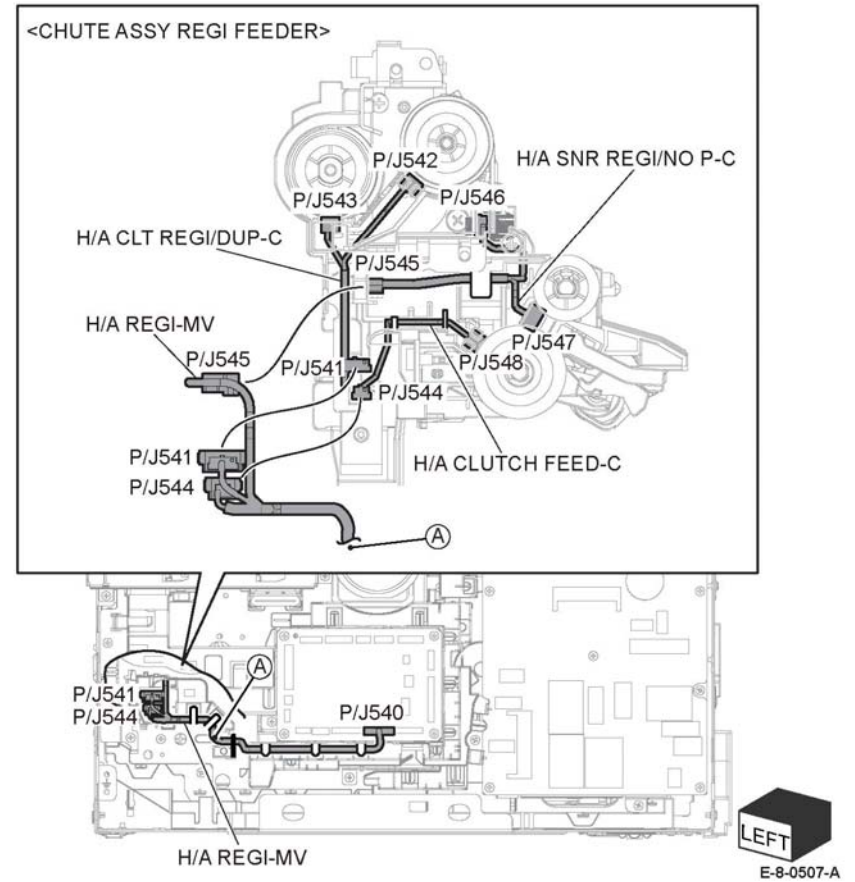
Figure 5 Registration/Duplex Clutch, Feed Clutch, Registration-MV, Registration Sensor, no paper sensor.

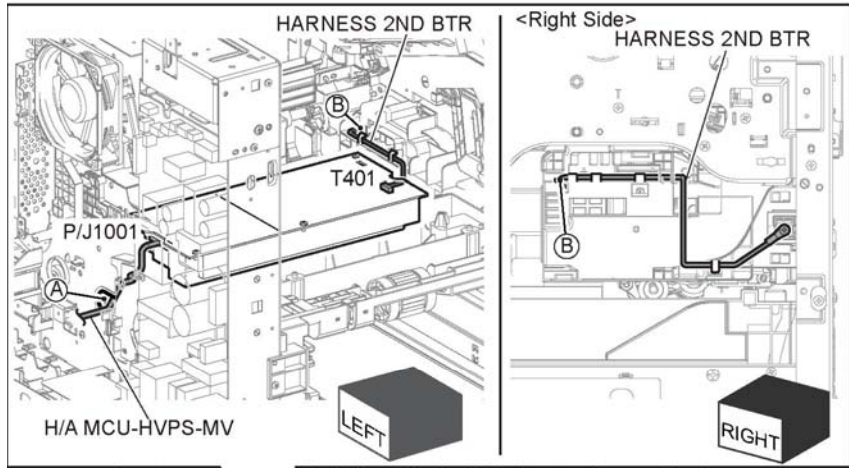
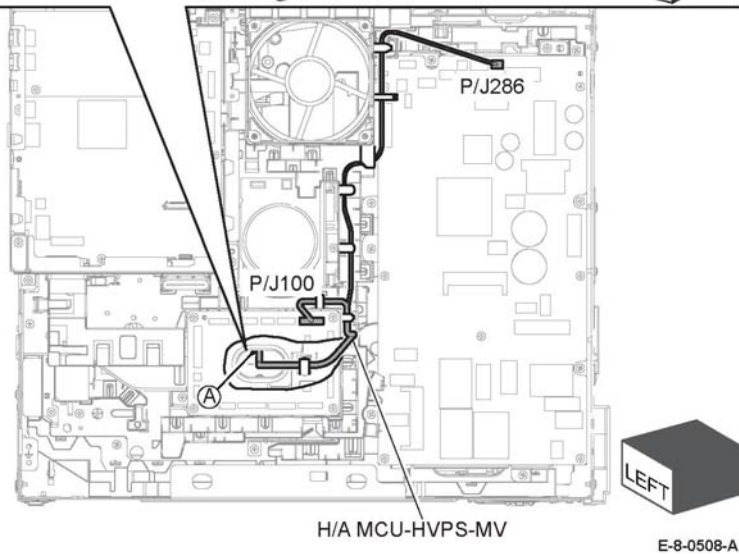
Figure 6 BTR, MCU HVPS-MV

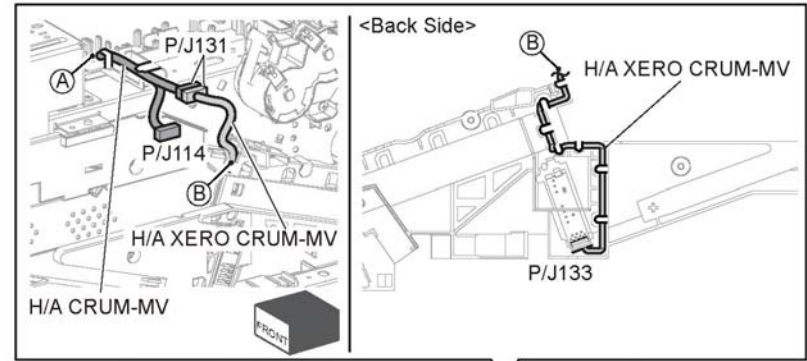
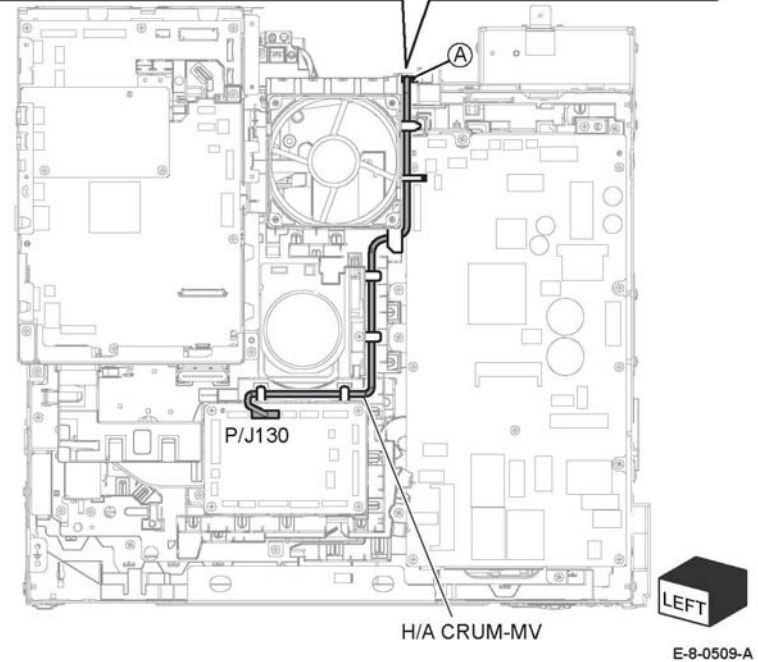
Figure 7 CRUM-MV, xerographic CRUM-MV

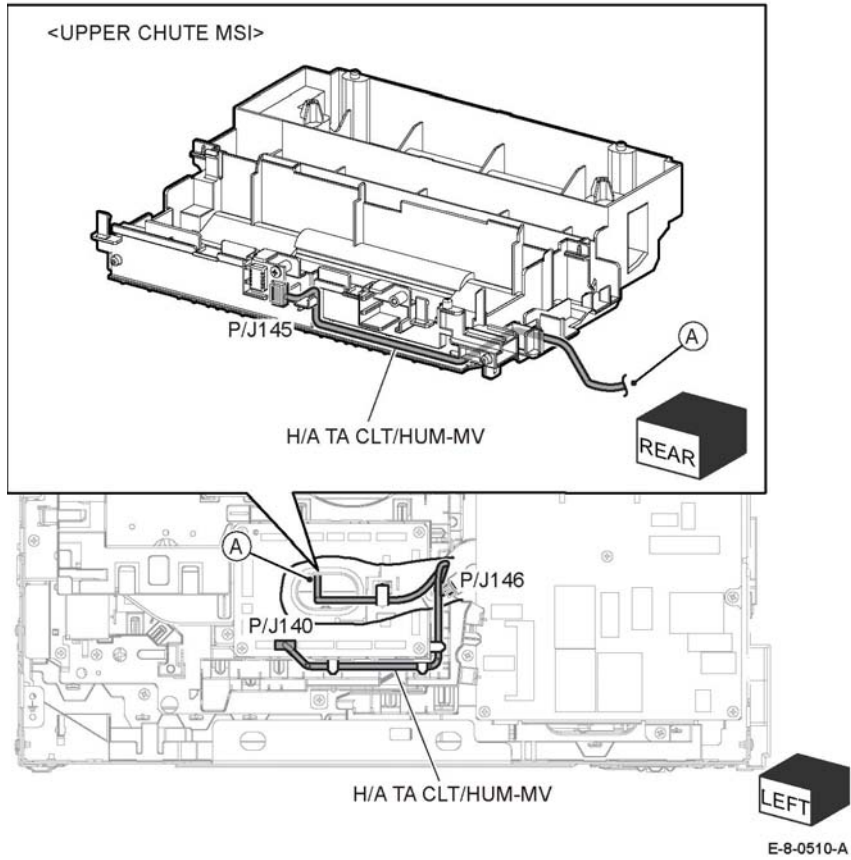
Figure 8 Take away clutch, Humidity-MV

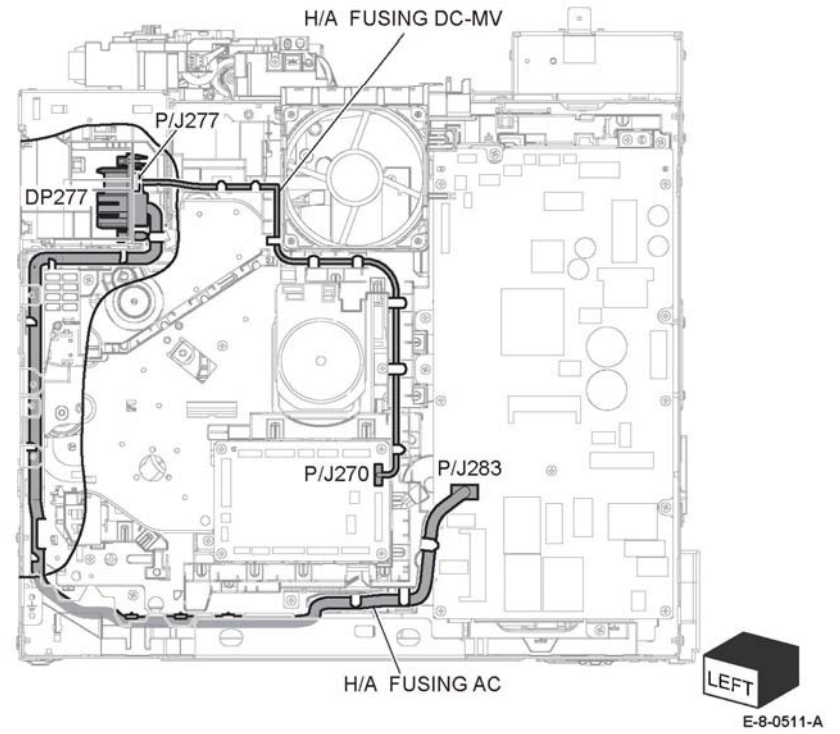
Figure 9 Fusing AC, Fusing DC-MV

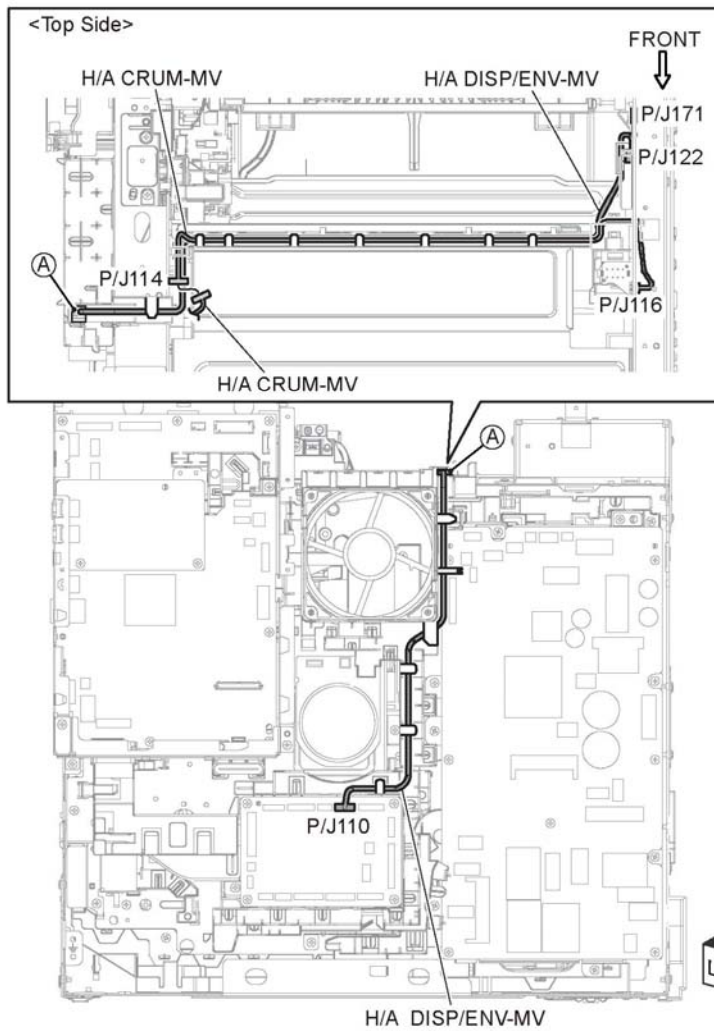
Figure 10 Dispenser, Environmental-MV, CRUM-MV

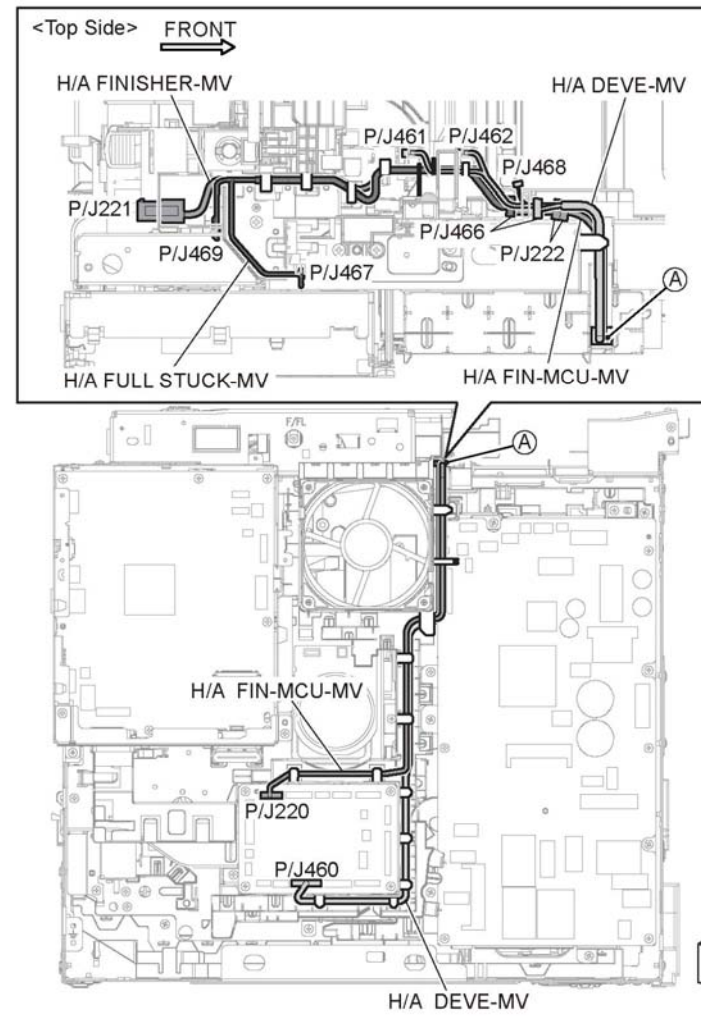
Figure 11 Finisher-MV, finisher MCU-MV, developer-MV, full stack-MV

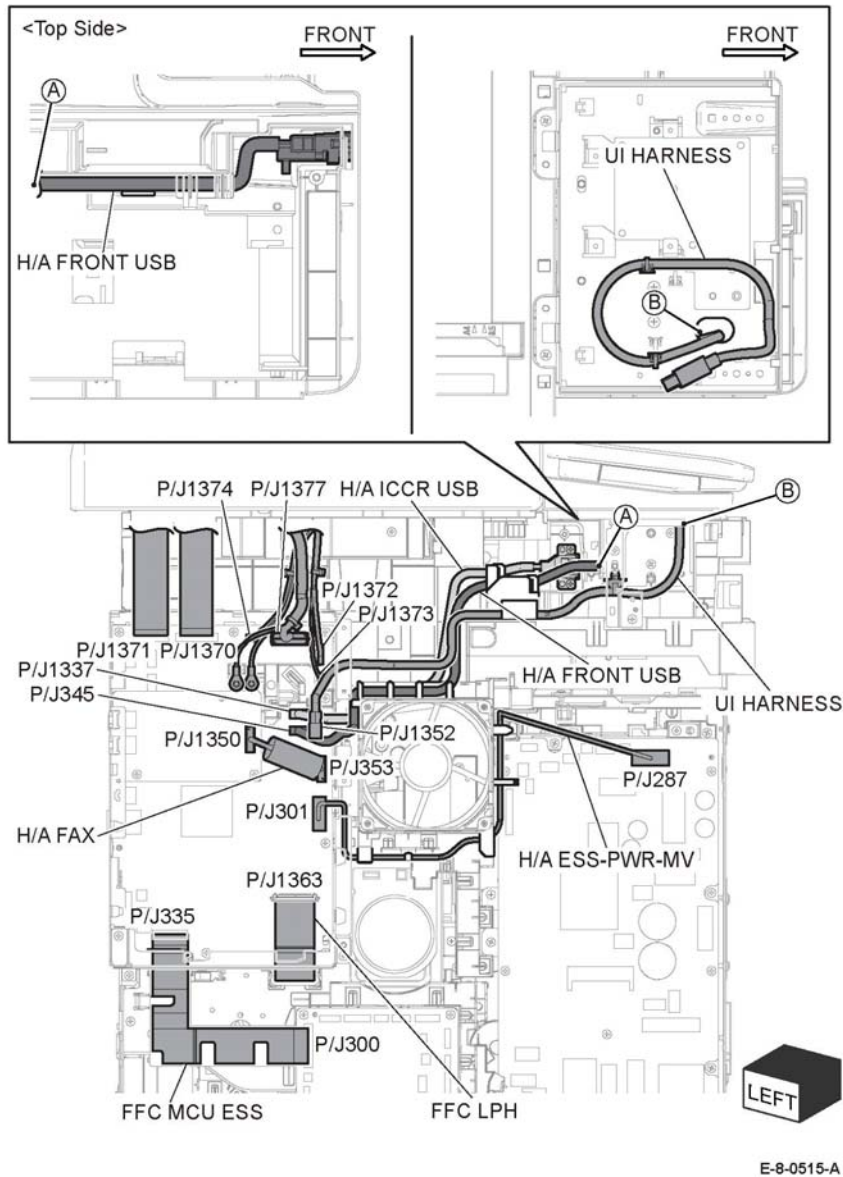
Figure 12 UI, FFC MCU ESS, fax, ICCR USB, front USB, ESS power-MV, DADF/IIT, FCC LPH (MFP std)

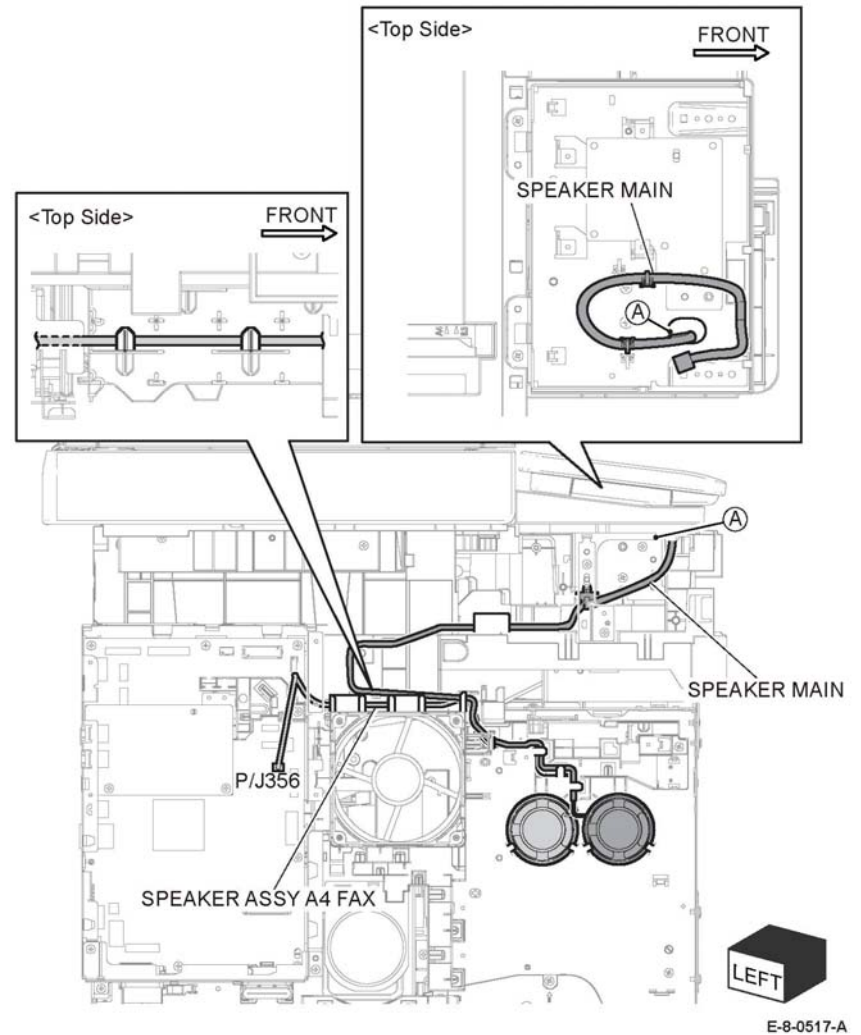
Figure 13 Speaker assembly A4 fax, Main Speaker (MFP std)

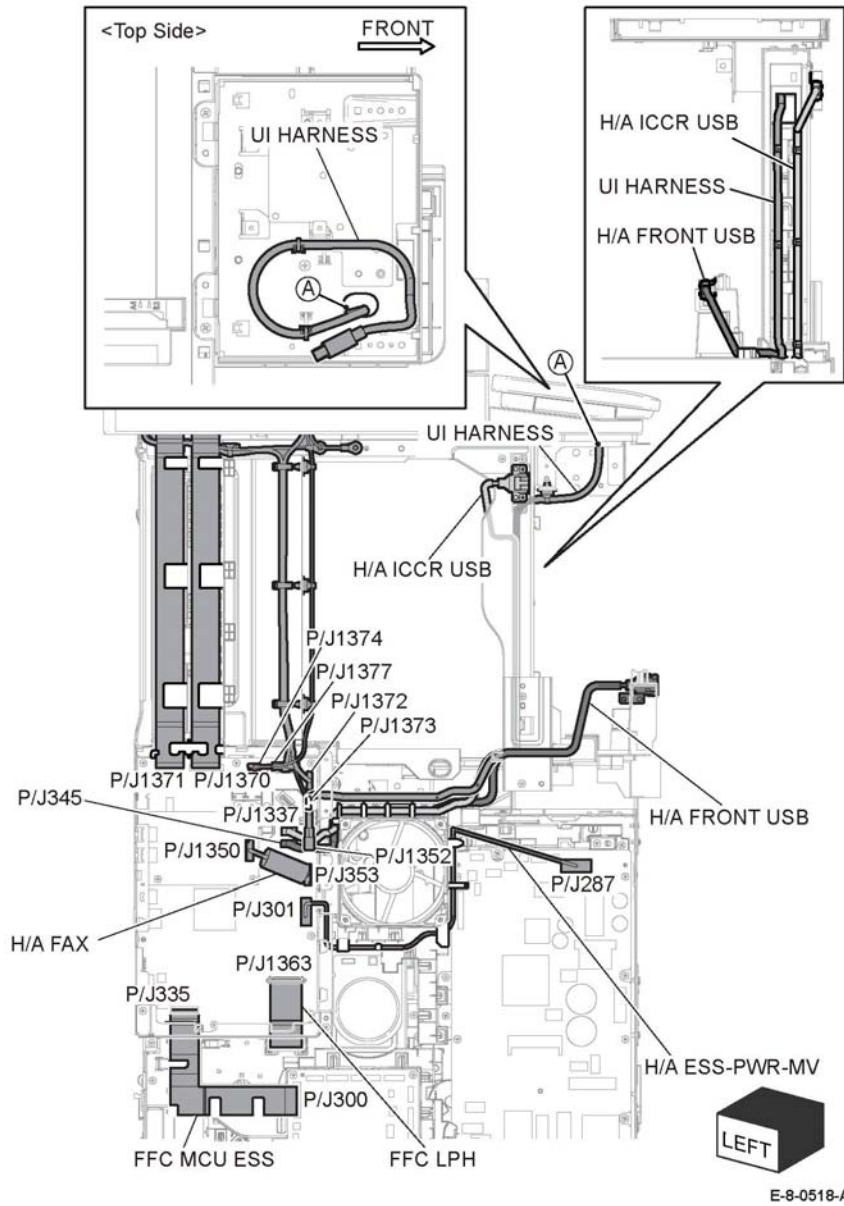
Figure 14 UI, FFC MCU ESS, fax, ICCR USB, front USB, ESS power-MV, DADF/IIT, FCC LPH (MFP-tall)

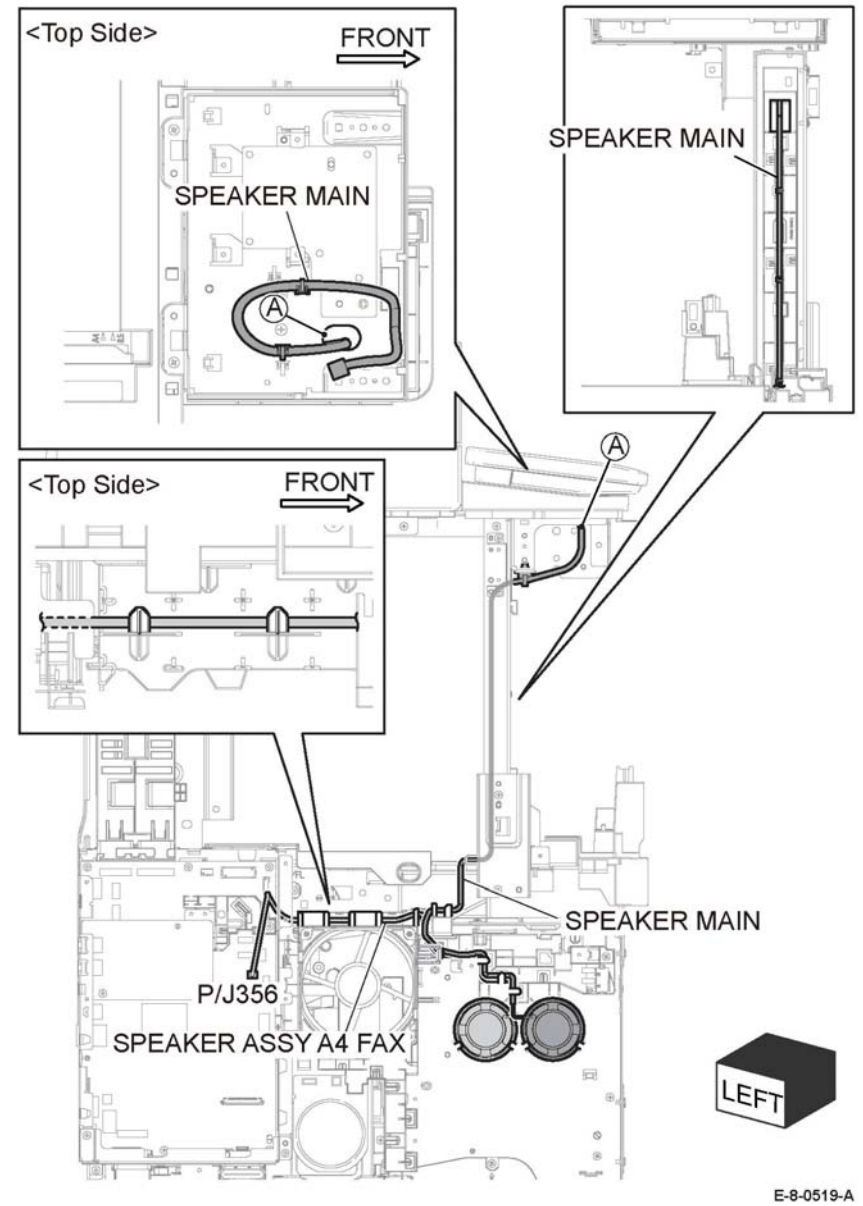
Figure 15 Speaker assembly A4 fax, Main Speaker (MFP tall)

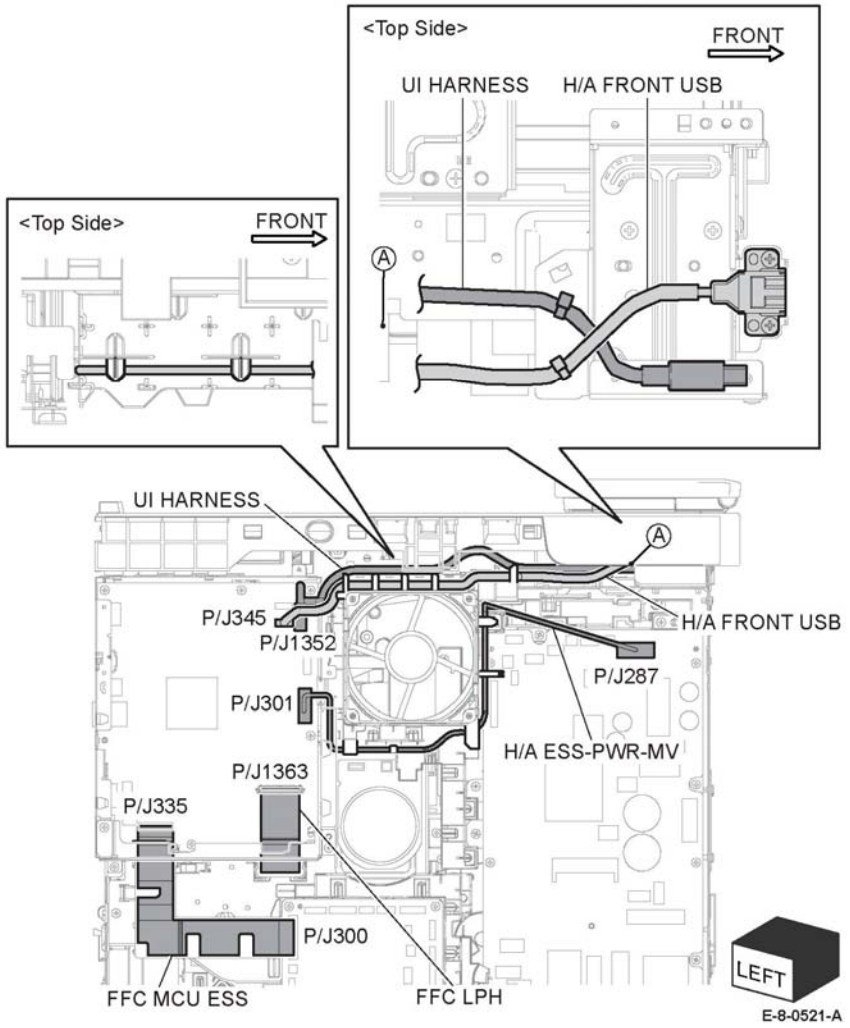
Figure 16 UI, FFC MCU ESS, front USB, ESS Power-MV, FFC LPH (SFP)

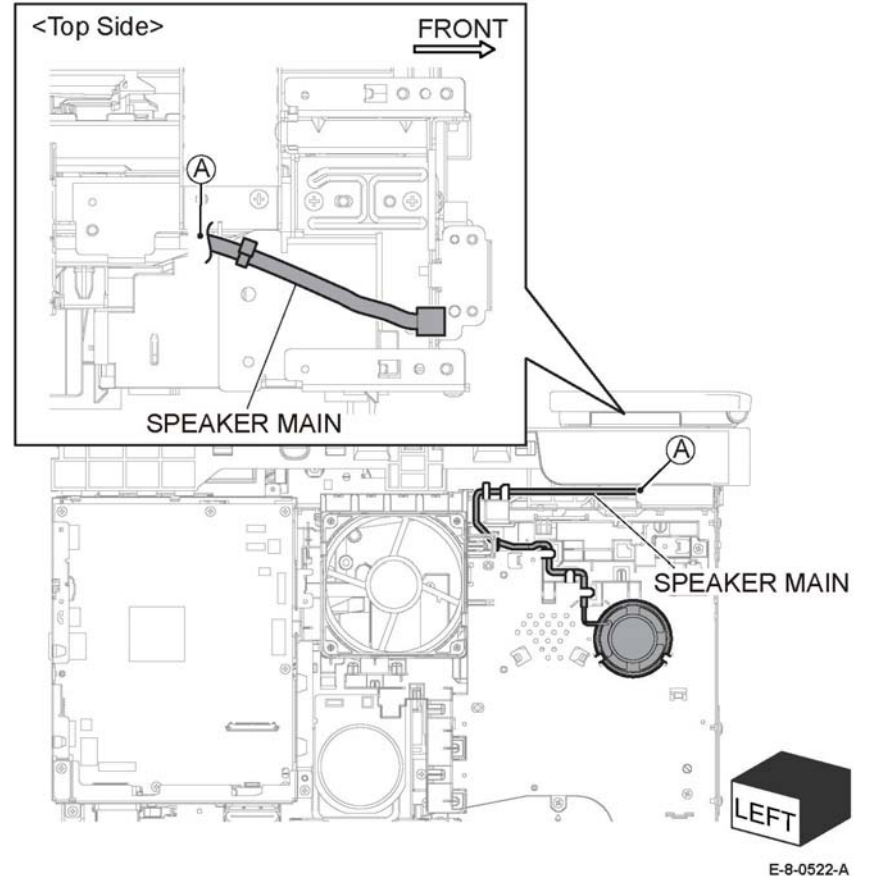
Figure 17 Main speaker (SFP)

Figure 17	Main speaker (SFP)

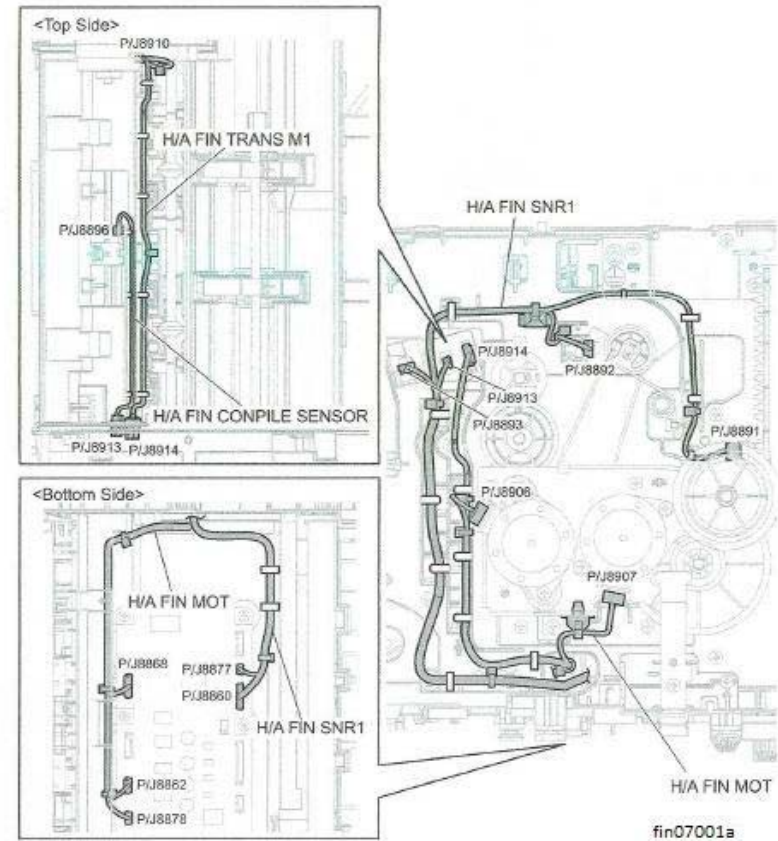
**Figure 1 Finisher motor, compile sensor, sensor 1**

Diagrams	Description
<a href="#">Figure 1</a>	Finisher motor, compile sensor, sensor 1
<a href="#">Figure 2</a>	Finisher I/L and stapler
<a href="#">Figure 3</a>	Finisher tamper motor
<a href="#">Figure 4</a>	Finisher AC and DC

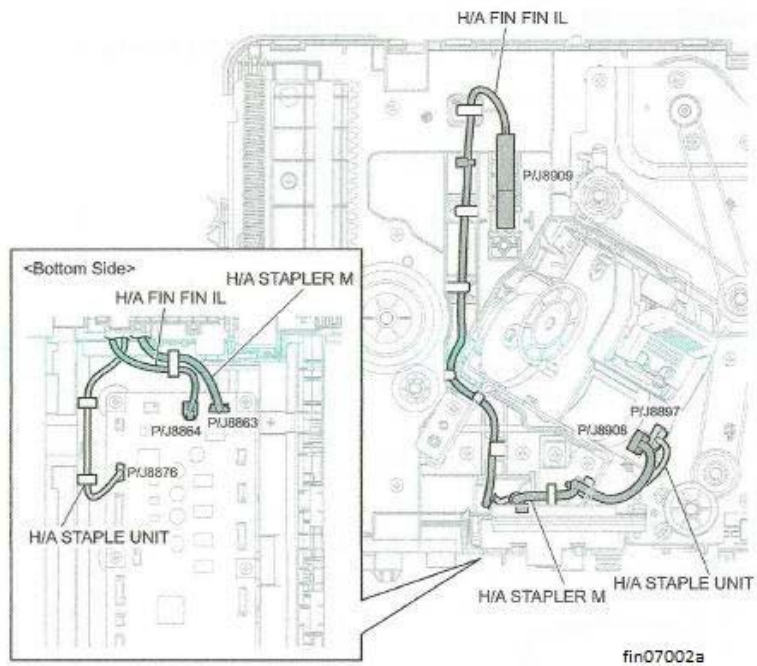
Figure 2 Finisher I/L and stapler

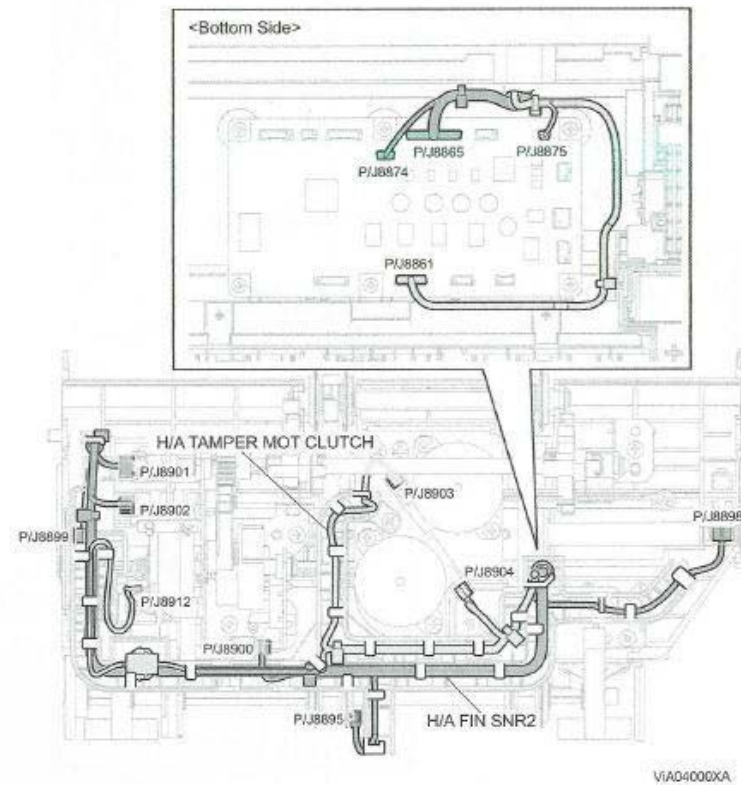
Figure 3 Finisher tamper motor

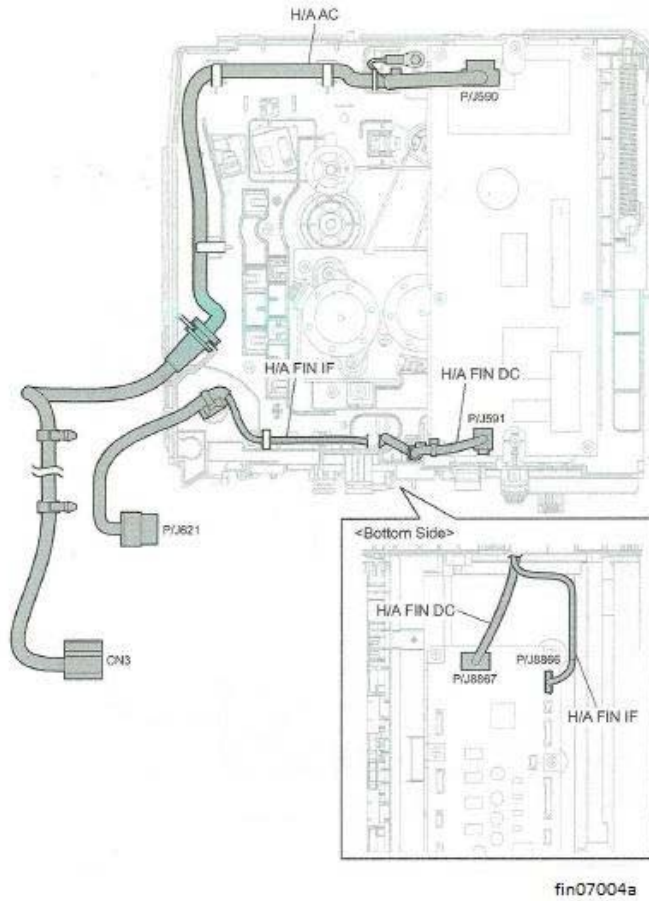
**Figure 4 Finisher AC and DC**

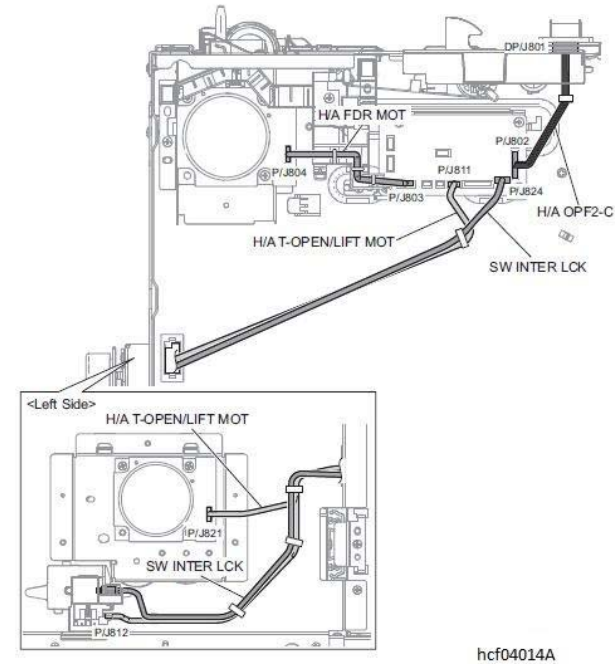
**Figure 1 T-open, lift motor, rear interlock switch, FDR motor, OPF2-C**

Diagrams	Description
Figure 1	T-open, lift motor, rear interlock switch, FDR motor, OPF2-C
Figure 2	Feed, lift motor I/L, lift up sensor
Figure 3	Turn
Figure 4	OPF LED

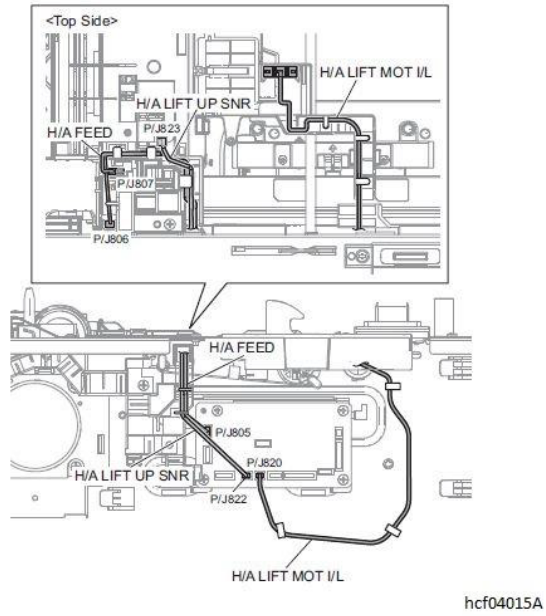
Figure 2 Feed, lift motor I/L, lift up sensor

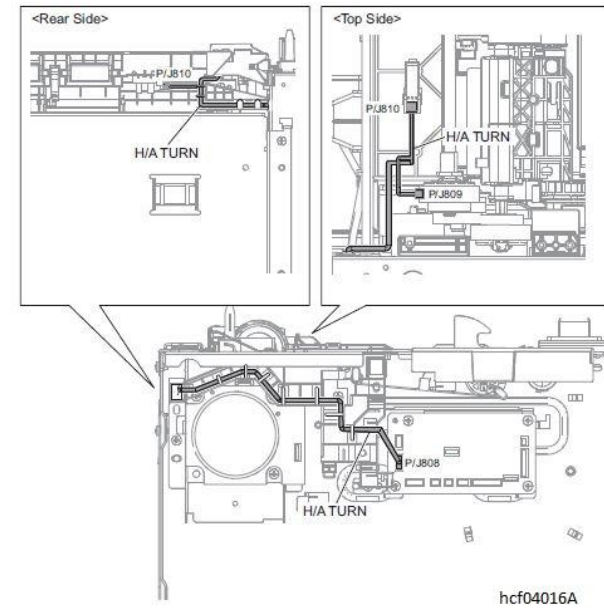
Figure 3 harness for turn

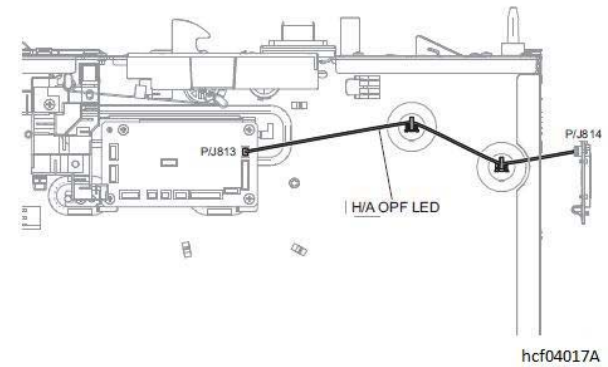
Figure 4 harness for OFF LED

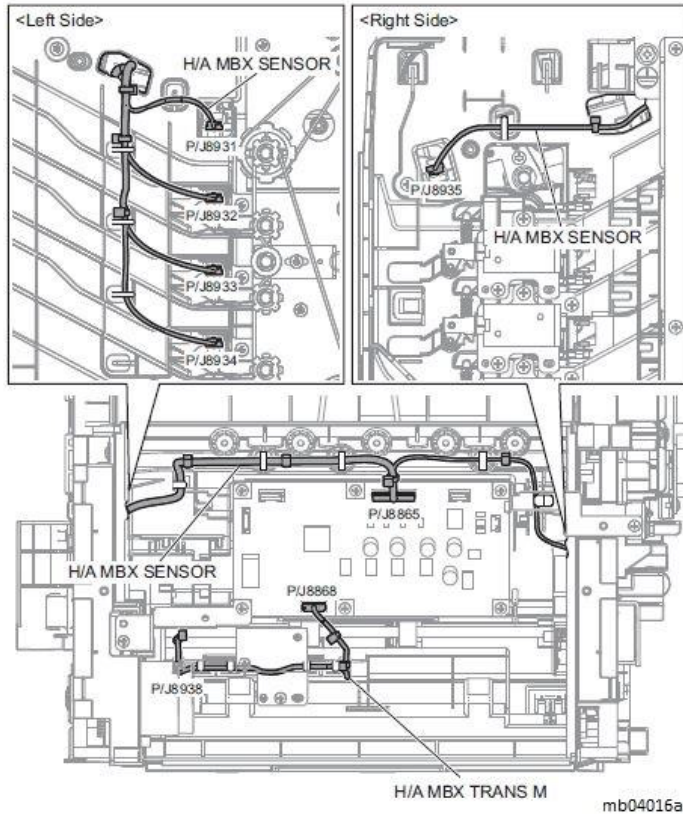
**Figure 1 MBX sensor/harness assembly MBX trans M**

Diagrams	Description
Figure 1	MBX sensor/harness assembly MBX trans M
Figure 2	Vertical sensor and LED
Figure 3	Trans S
Figure 4	MBX IF/ harness assembly MBX AC and DC

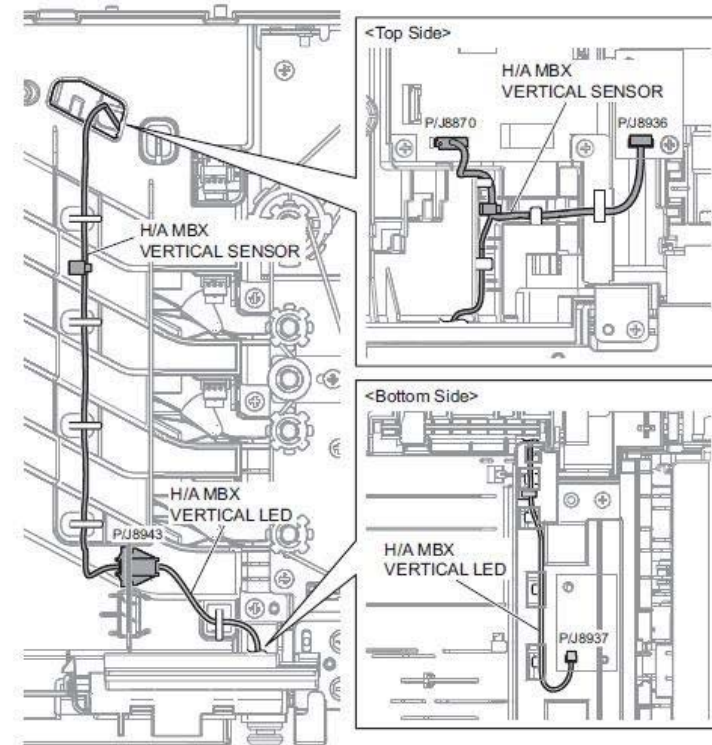
**Figure 2 Vertical sensor and LED**

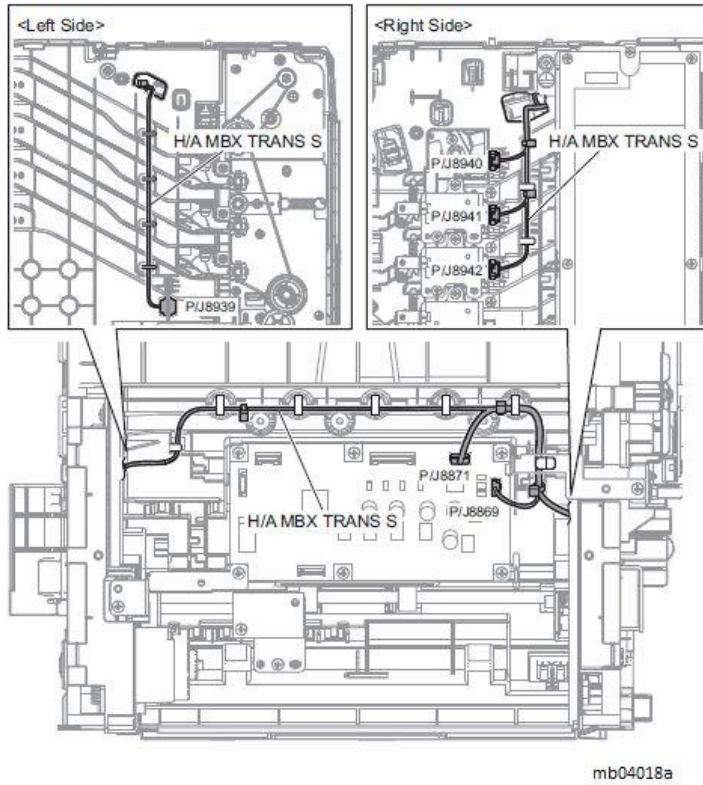
Figure 3 Trans S

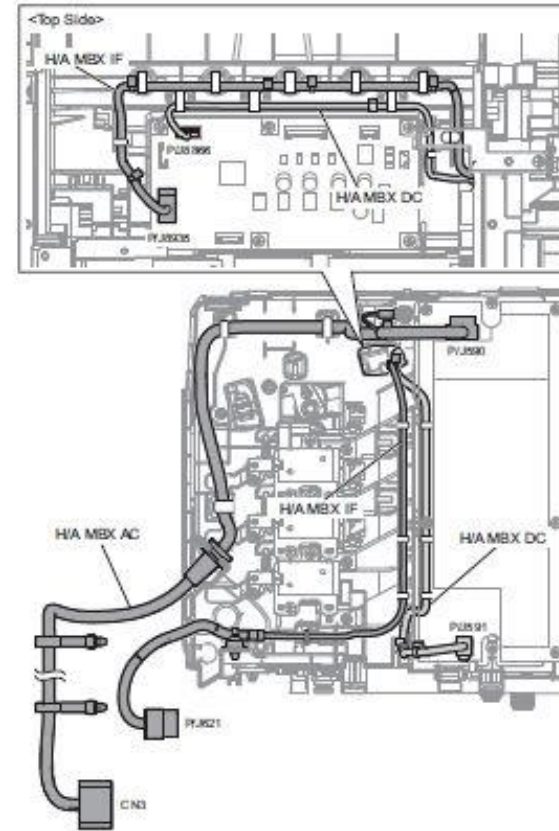
Figure 4 MBX IF/ harness assembly MBX AC and DC

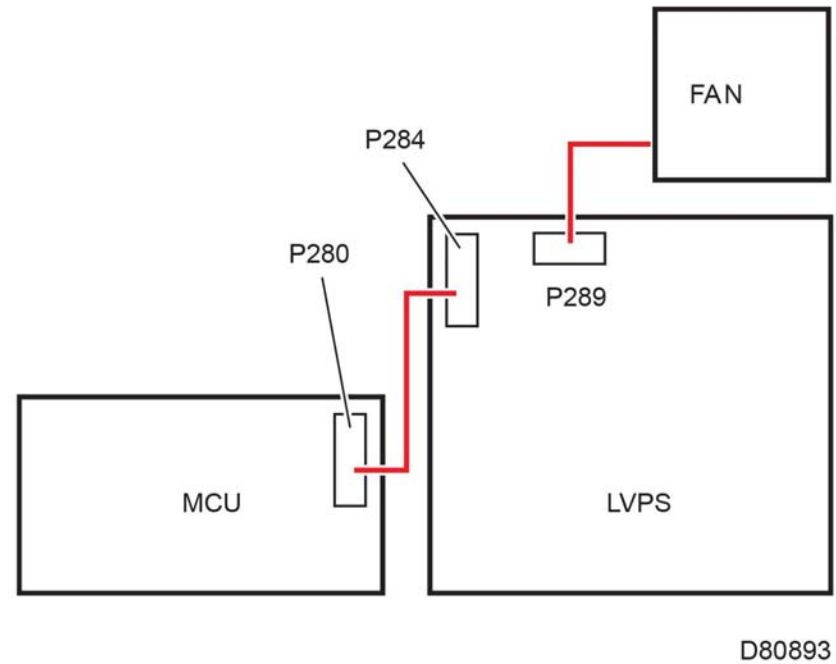
D80893

**Figure 1 MCU, LVPS, fan**

Diagram	Description
Figure 1	MCU, LVPS, fan
Figure 2	MCU, OP-FDA 550, OP-FDR-MCU
Figure 3	CTD sensor assembly
Figure 4	Motor, MCU, LVPS
Figure 5	Fusing, MCU, LVPS
Figure 6	ESS, MCU
Figure 7	REGI, NPP, tray1 MCU
Figure 8	MSI no paper sensor, MCU
Figure 9	Rear fan, MCU, LVPS
Figure 10	Sub fan, MCU, LVPS
Figure 11	IOT, MCU, HCF, OPF PWB
Figure 12	Optional feeder 550, upper OPF 550, upper HCF, OPF PWB
Figure 13	MCU, toner cover sensor
Figure 14	DEVE solenoid, MCU
Figure 15	MCU, HVPS
Figure 16	Exit sensor, MCU
Figure 17	TA CLT, MSI SOL, MCU
Figure 18	Feed clutch, REGI clutch, MCU
Figure 19	REGI Clutch, MCU
Figure 20	Exit clutch, REGI clutch
Figure 21	I/L side, MCU, LVPS
Figure 22	I/L rear, MCU, LVPS
Figure 23	Switching CLT(K CLT), switching SNR(K SNR), MCU
Figure 24	550 OPF PWB, OPT path PPR SNR
Figure 25	550 OPF PWB, optional feed clutch
Figure 26	550 OPF PWB, OPT take away clutch
Figure 27	550 OPF PWB, OPF forward motor
