# VersaLink® B600/B610 Printer and B605/B615 Multifunction Printer Service Manual

Xerox® VersaLink® B600 Family MFP Service Manual

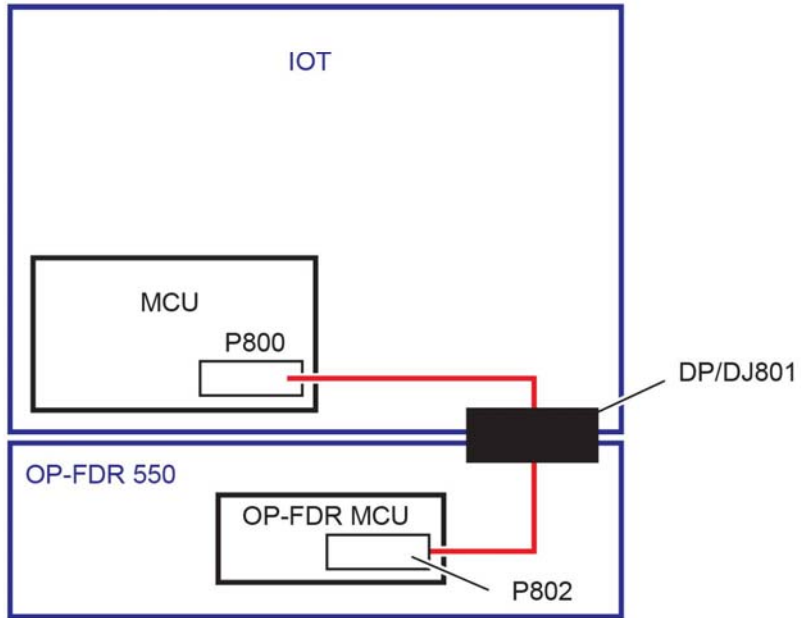
D80894

Figure 2 MCU, OP-FDR 550

Diagram	Description
Figure 1	MCU, LVPS, fan
Figure 2	MCU, OP-FDA 550, OP-FDR-MCU
Figure 3	CTD sensor assembly
Figure 4	Motor, MCU, LVPS
Figure 5	Fusing, MCU, LVPS
Figure 6	ESS, MCU
Figure 7	REGI, NPP, tray1 MCU
Figure 8	MSI no paper sensor, MCU
Figure 9	Rear fan, MCU, LVPS
Figure 10	Sub fan, MCU, LVPS
Figure 11	IOT, MCU, HCF, OPF PWB
Figure 12	Optional feeder 550, upper OPF 550, upper HCF, OPF PWB
Figure 13	MCU, toner cover sensor
Figure 14	DEVE solenoid, MCU
Figure 15	MCU, HVPS
Figure 16	Exit sensor, MCU
Figure 17	TA CLT, MSI SOL, MCU
Figure 18	Feed clutch, REGI clutch, MCU
Figure 19	REGI Clutch, MCU
Figure 20	Exit clutch, REGI clutch
Figure 21	I/L side, MCU, LVPS
Figure 22	I/L rear, MCU, LVPS
Figure 23	Switching CLT(K CLT), switching SNR(K SNR), MCU
Figure 24	550 OPF PWB, OPT path PPR SNR
Figure 25	550 OPF PWB, optional feed clutch
Figure 26	550 OPF PWB, OPT take away clutch
Figure 27	550 OPF PWB, OPF forward motor

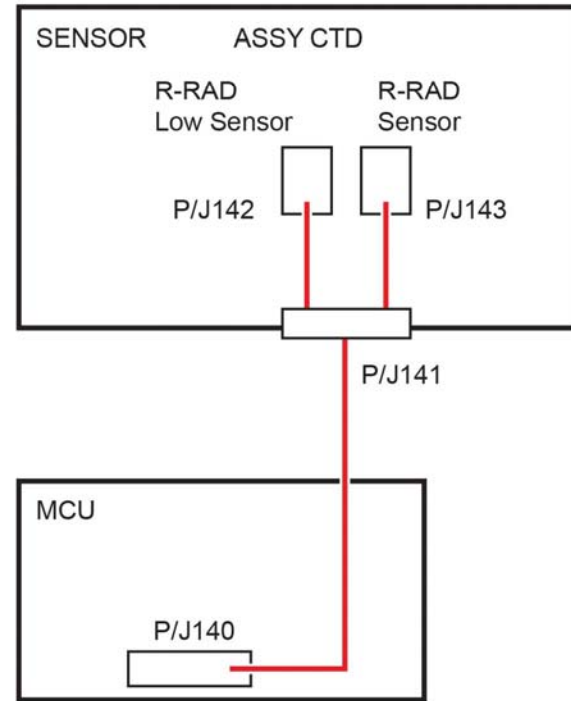
D80895

Figure 3 R-RAD sensor

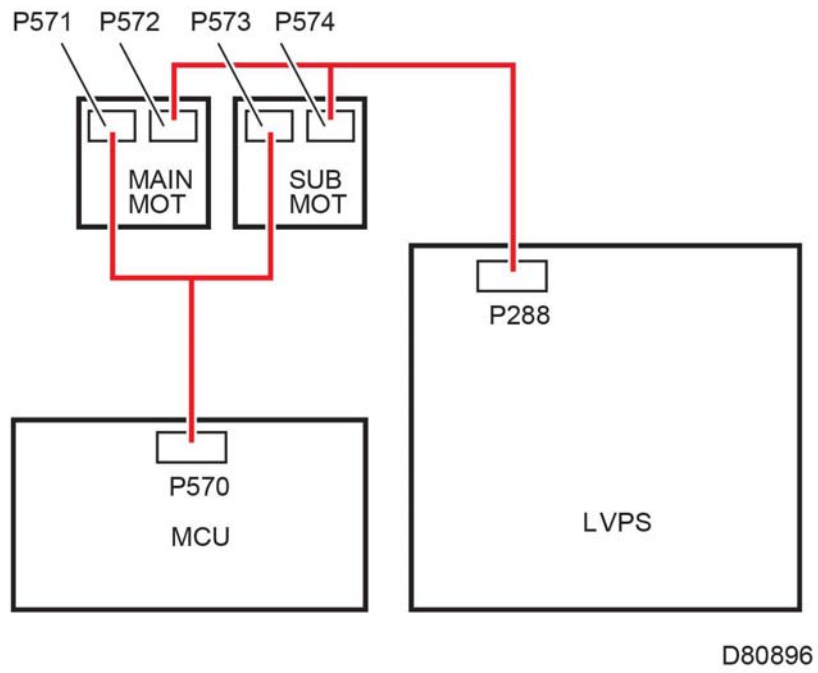
Figure 4 Main motor

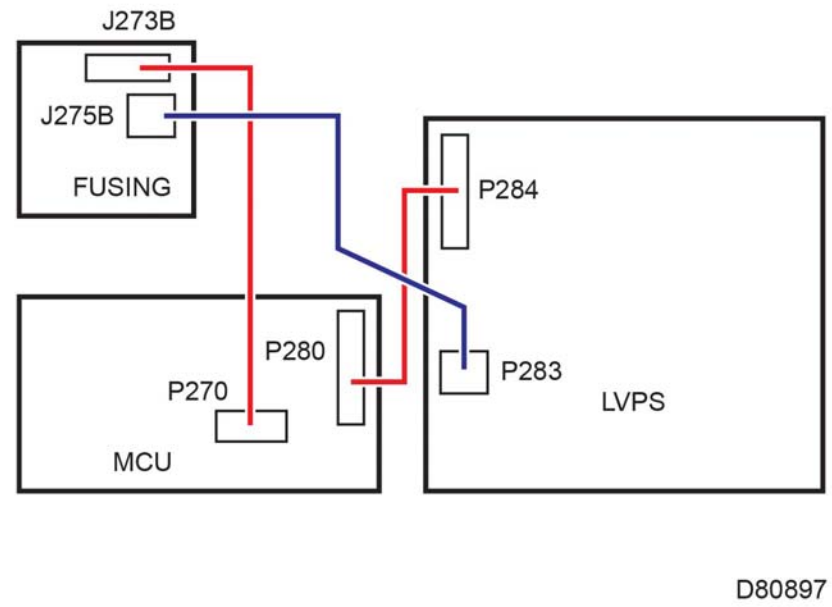
Figure 5 Fusing

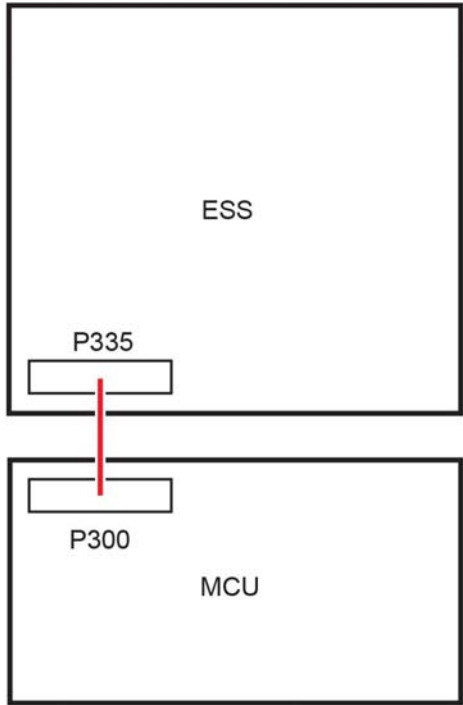
D80898

Figure 6 ESS

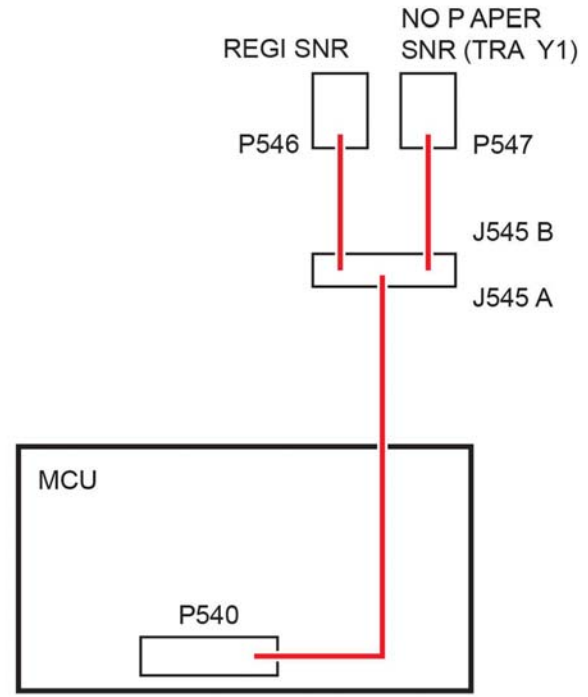
D80899

Figure 7 REGI

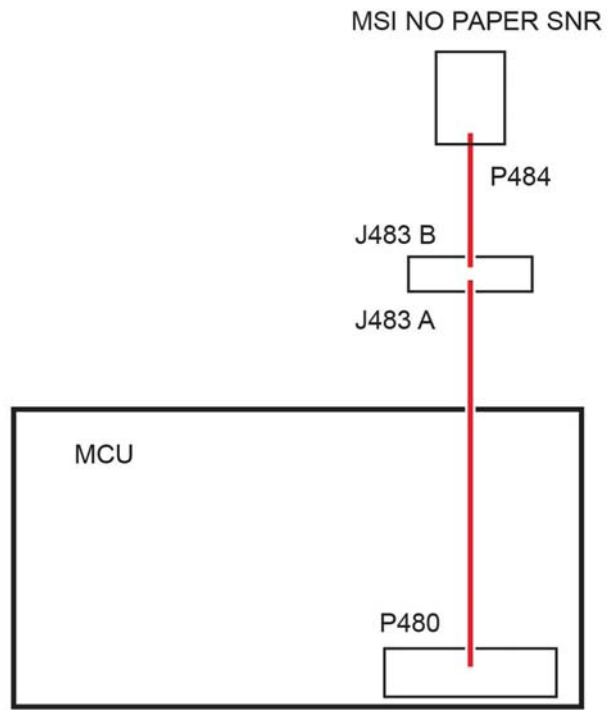
D80900

Figure 8 MSI no paper sensor

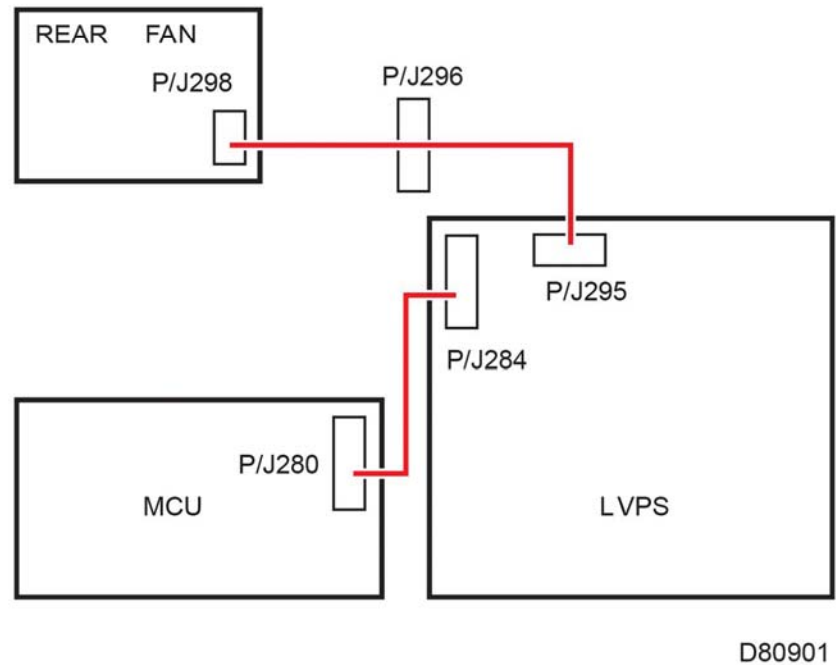
D80901

Figure 9 Supply Rear fan

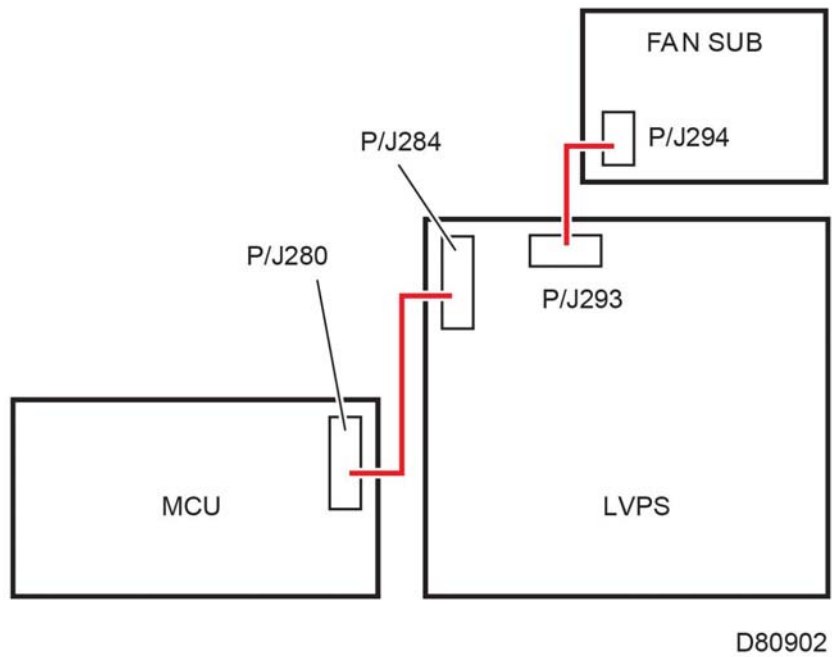
Figure 10 Sub fan

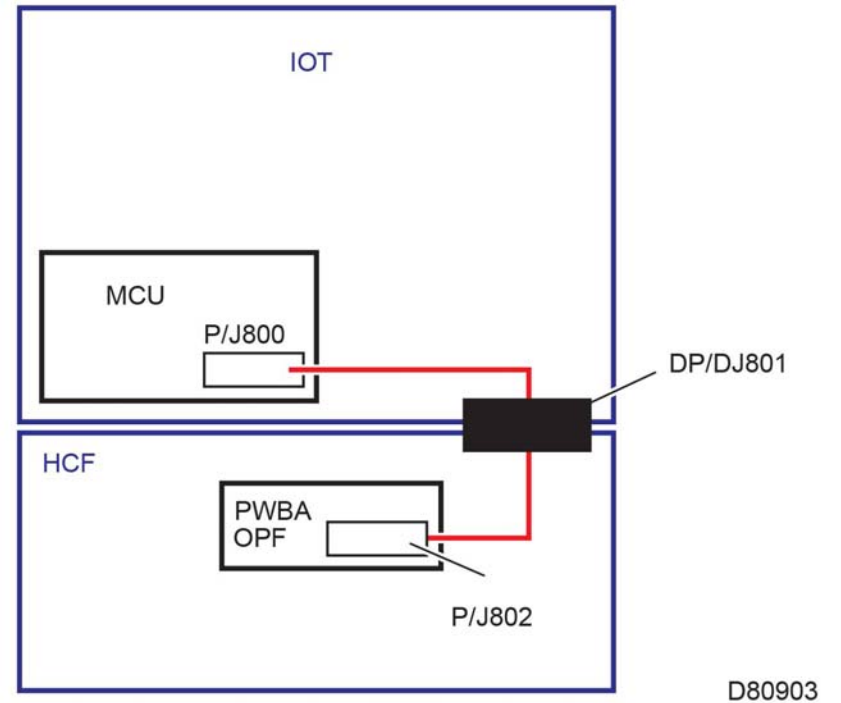
Figure 11 IOT and HCF

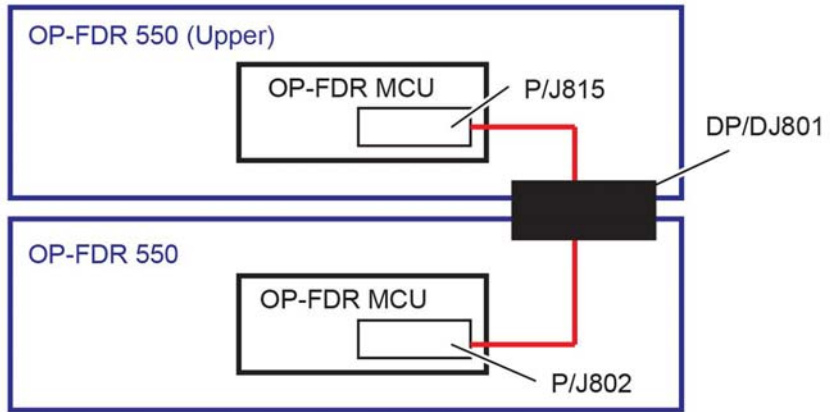
D80904

Figure 12 Optional feeder

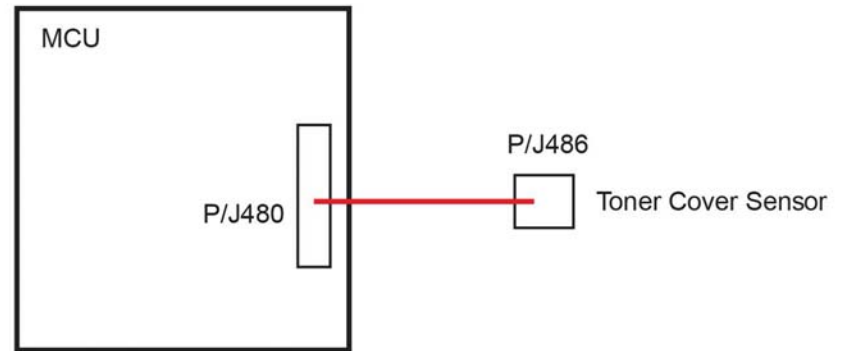
D80906

Figure 13 Toner cover sensor

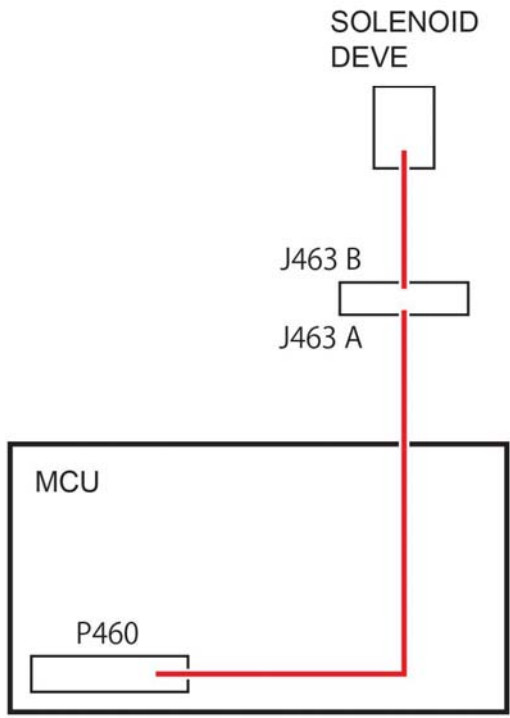
D80907

Figure 14 Solenoid drive

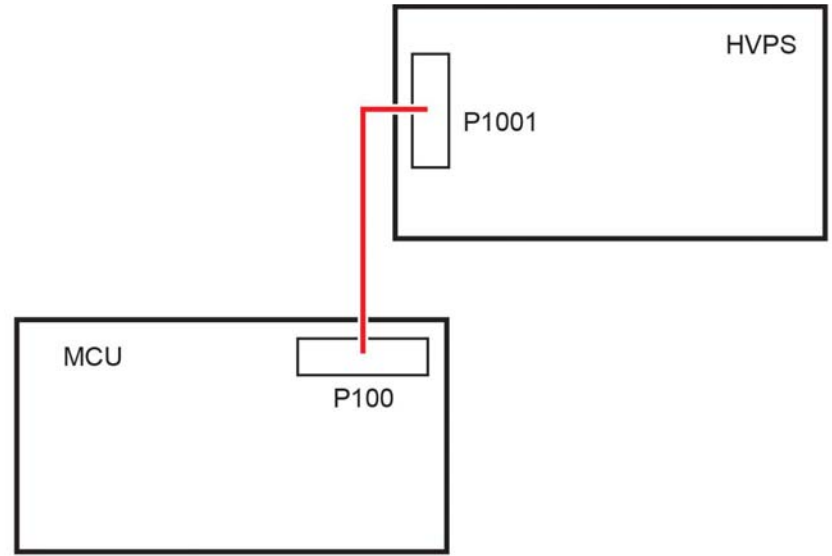
D80908

Figure 15 MCU and HVPS

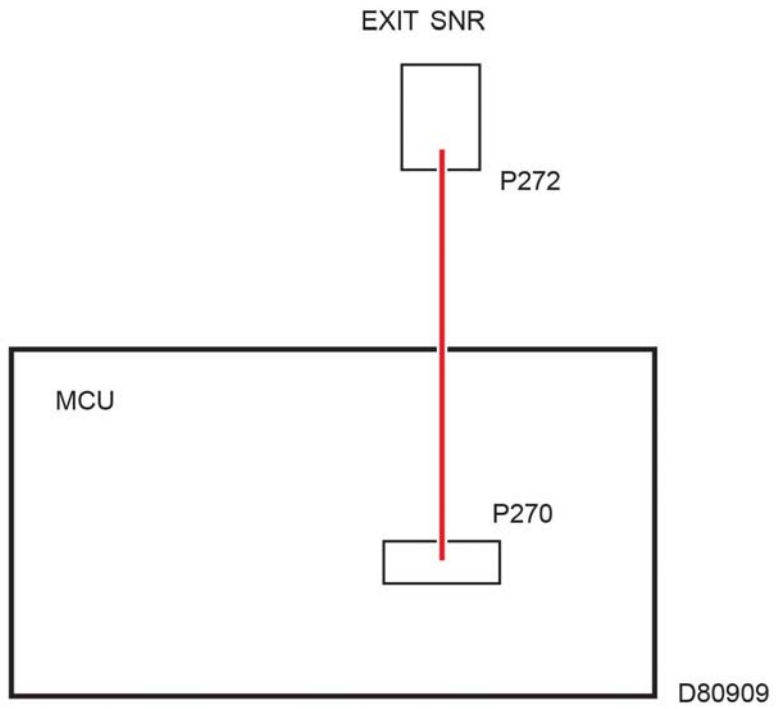
Figure 16 Exit sensor

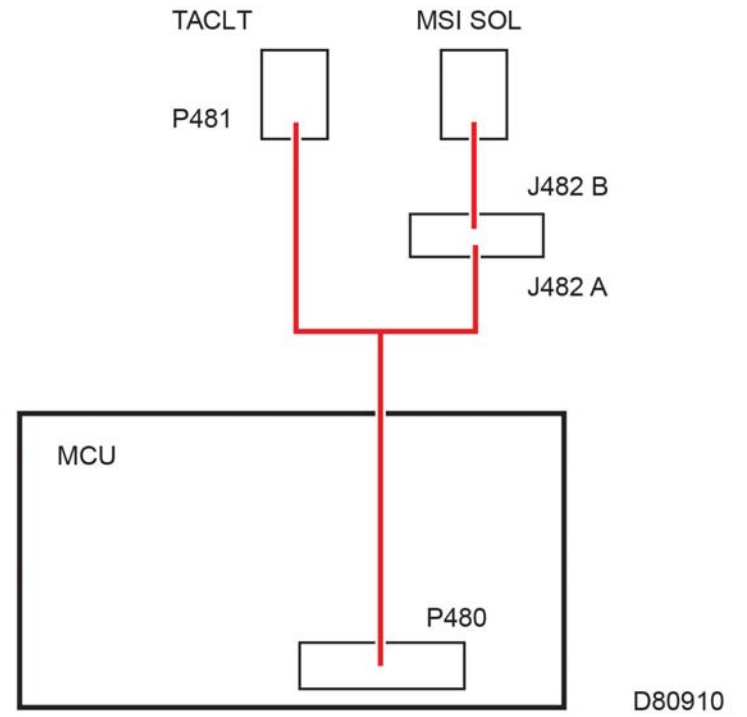
Figure 17 TCLT and MSI solenoid

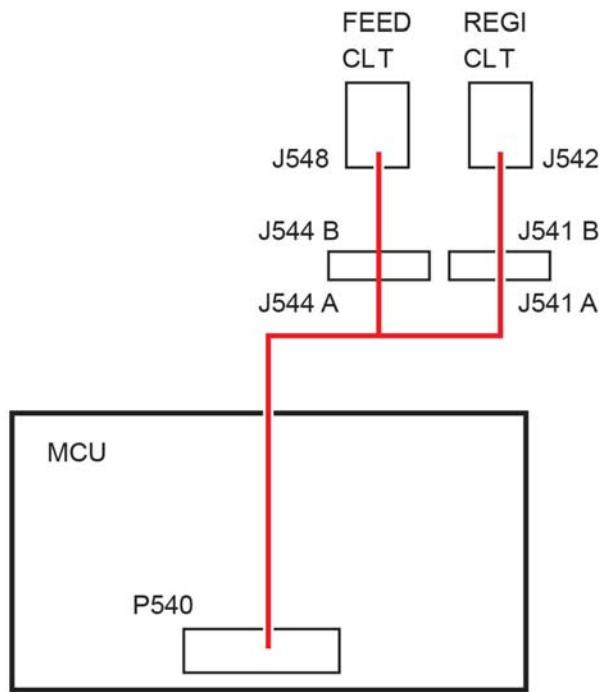
D80911

Figure 18 Feed and REGI clutch

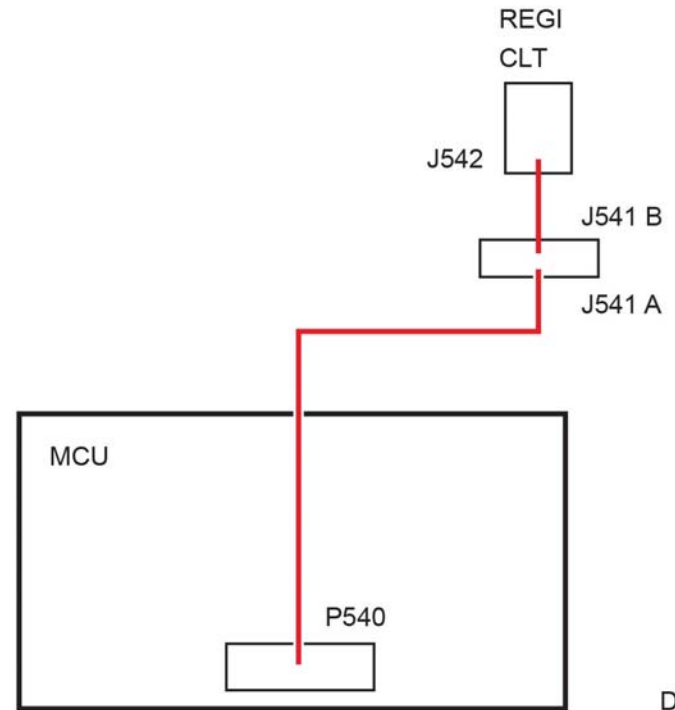
D80912

Figure 19 REGI clutch

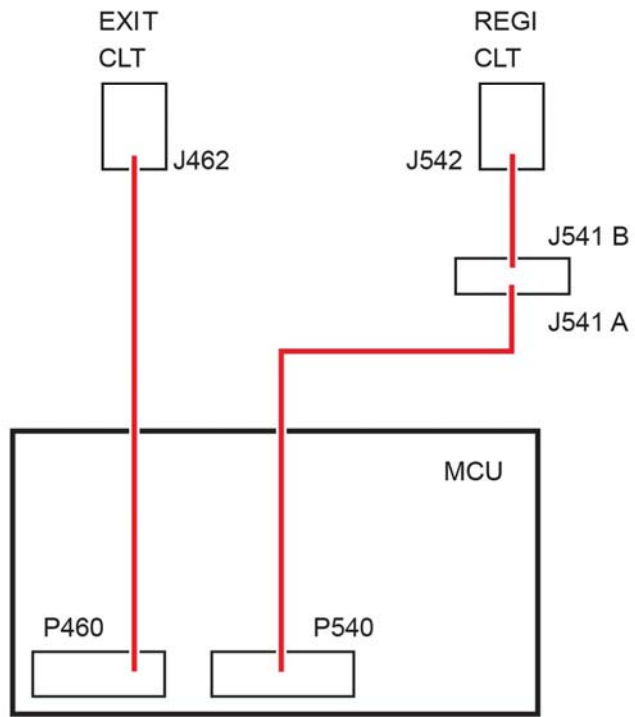
D80913

Figure 20 Exit clutch, REGI clutch

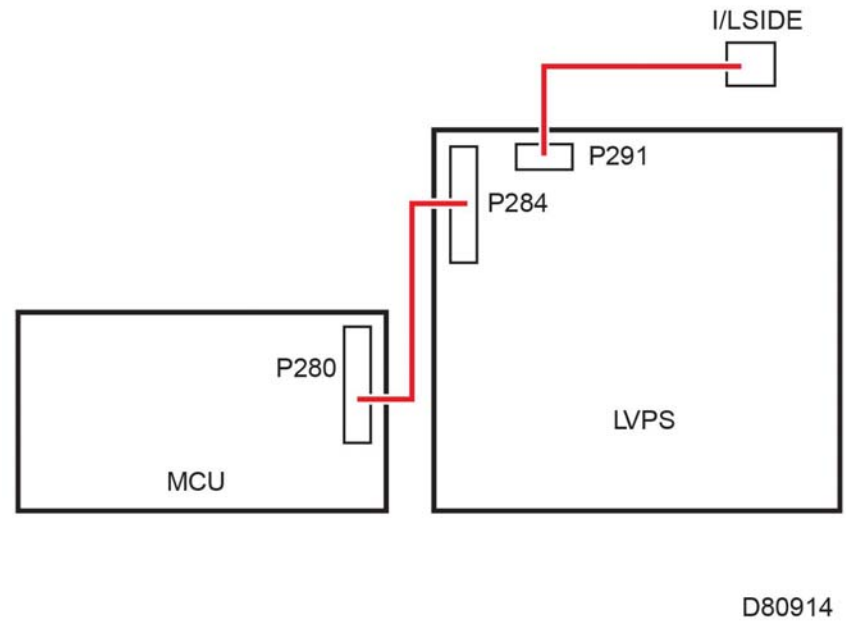
D80914

Figure 21 I/L side, MCU, LVPS

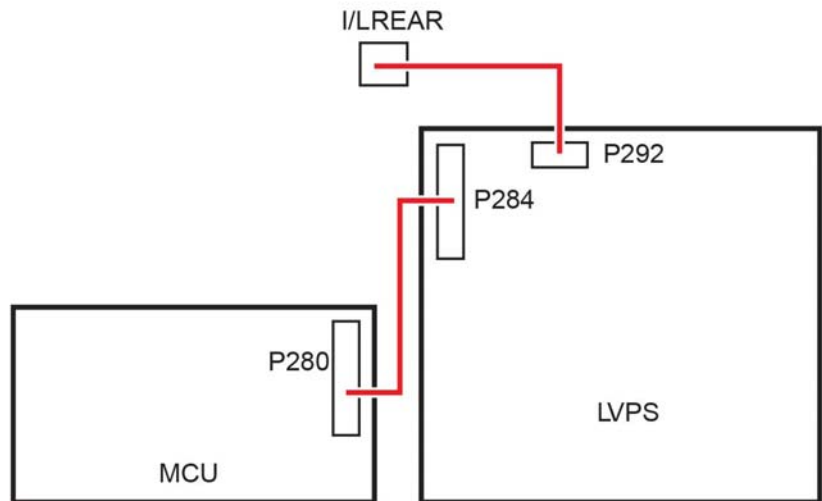
D80915

Figure 22 I/L rear, MCU, LVPS

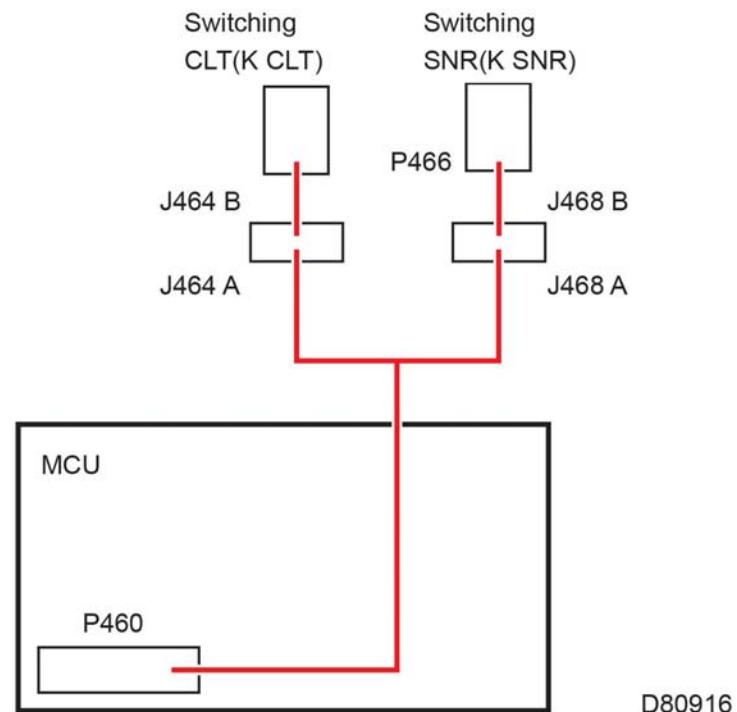
D80916

Figure 23 Switching CLT(K CLT), switching SNR(KSNR), MCU

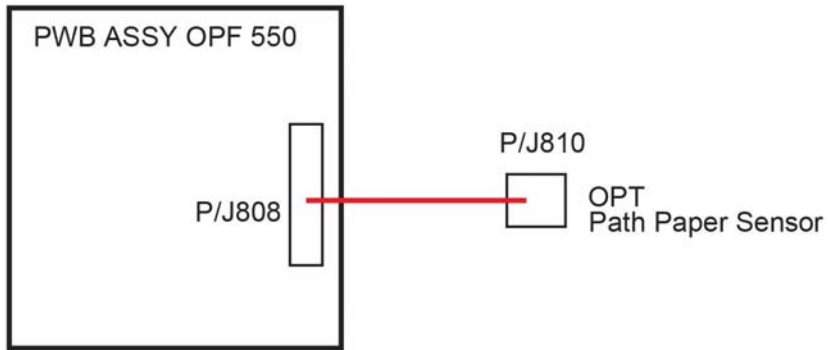
D80917

Figure 24 550 OPF PWB, OPT paper path SNR

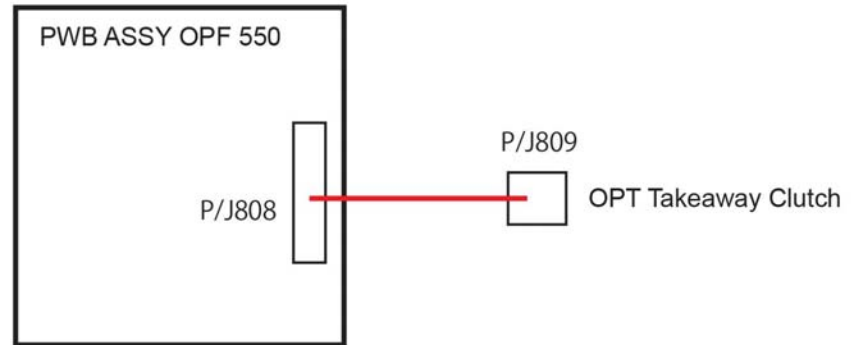
D80919

Figure 26 550 OPF PWB, OPF take away clutch

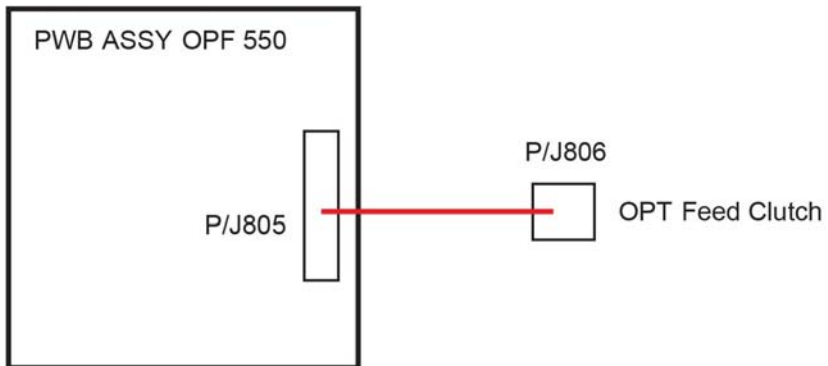
D80918

Figure 25 550 OPF PWB, optional feed clutch

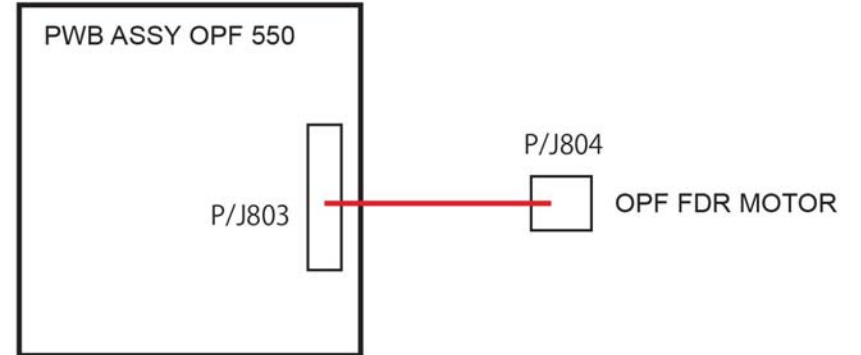
D80920

Figure 27 550 OPF PWB, OPF forward motor

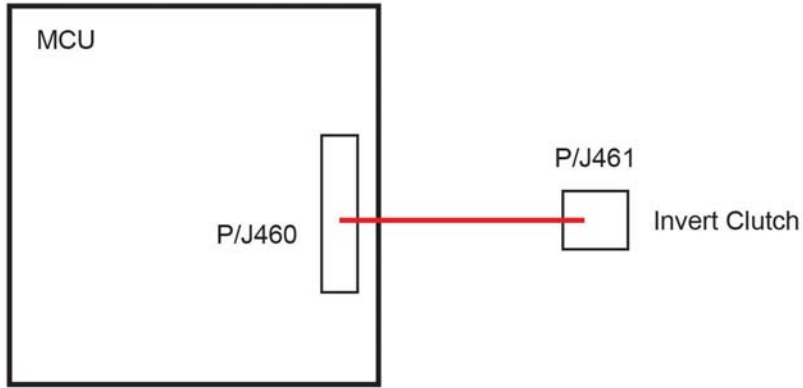
D80921

Figure 28 MCU, inverter clutch

Figure 28	MCU, inverter clutch
Figure 29	MCU, K module sensor
Figure 30	MCU, switching clutch assembly
Figure 31	OPF 550 PWB, OPF feeder no paper sensor
Figure 32	Sub motor, MCU, LVPS
Figure 33	MCU, envelope mode sensor
Figure 34	MCU, fusing envelope motor
Figure 35	OPF PWB, HCF paper path sensor

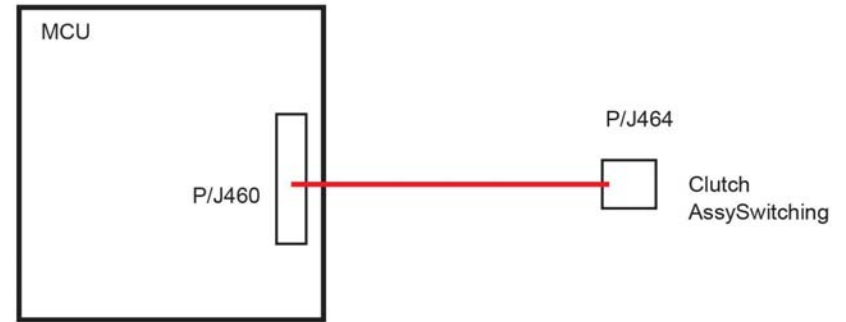
D80923

Figure 30 MCU, switching clutch assembly

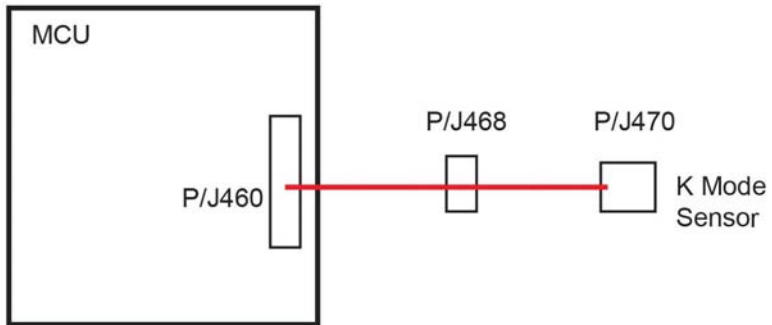
D80922

Figure 29 MCU, K module sensor

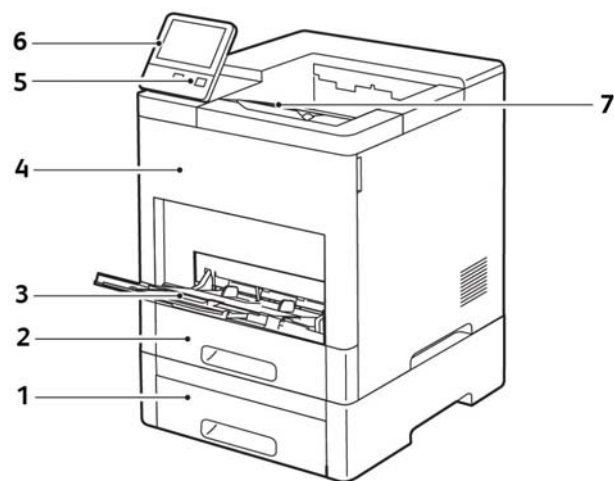
E-8-0924-A

Figure 1 VersaLink® B600 and B610 front and right side views shows the printer's front and right side views with parts identified in Table 1.

Figure 1 VersaLink® B600 and B610 SFP front and right side views

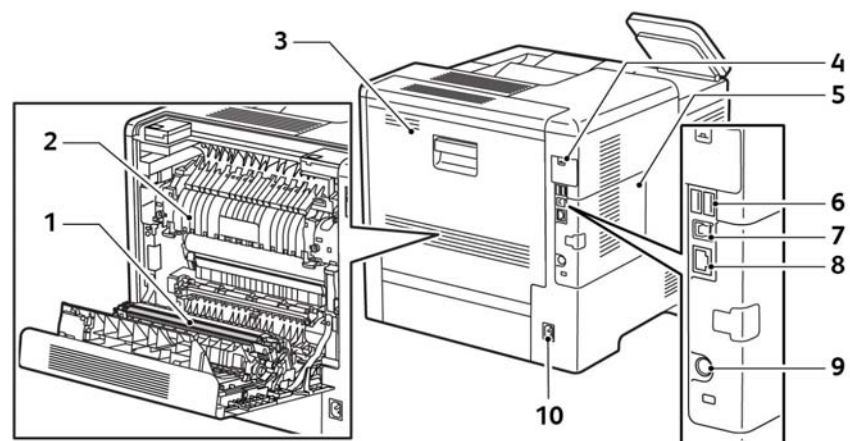
E-8-0925-A

Figure 2 VersaLink® B600 and B610 rear and left side views shows the printer's rear and left side views with parts identified in Table 2 rear and left side parts identification.

Figure 2 VersaLink® B600 and B610 SFP rear and left side views

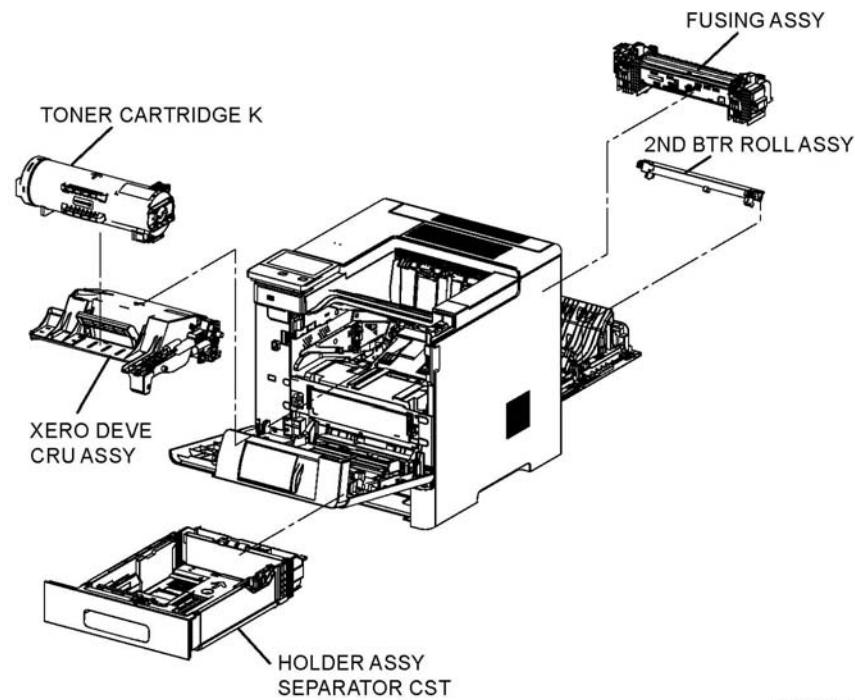
E-8-0594-A

Figure 3 VersaLink® B600 and B610 internal parts shows the printer's front and right side view with internal parts.

Figure 3 VersaLink® B600 and B610 internal parts

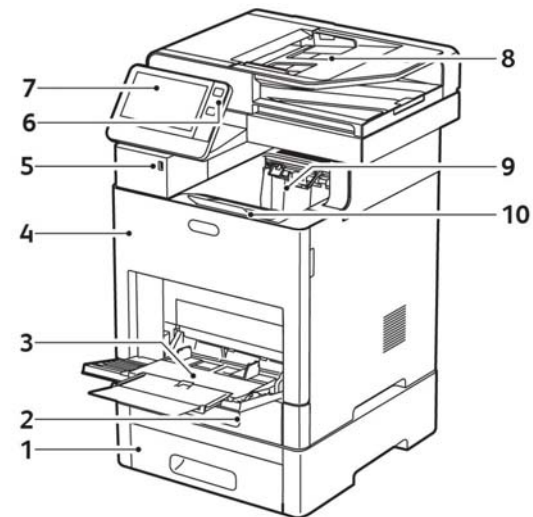
E-8-0926-A

Figure 4 shows the VersaLink® B605 and B615 front and right side view with parts identified in Table 3.

Figure 4 VersaLink® B605 and B615 MFP front and right side view

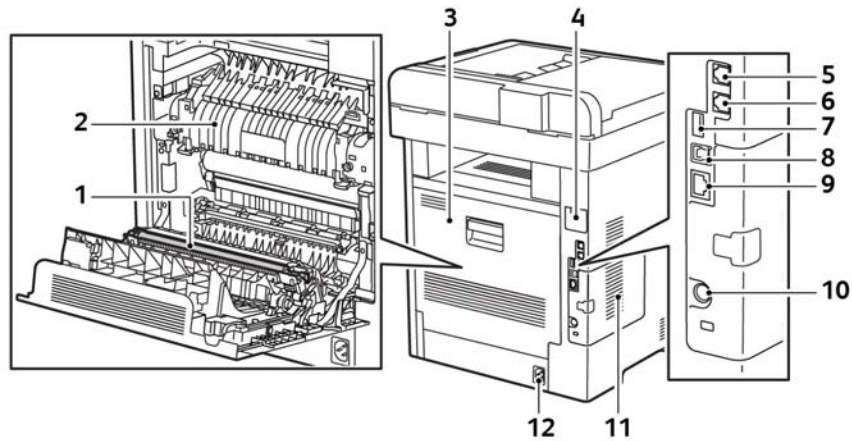
E-8-0927-A

Figure 5 VersaLink® B605 and B615 rear and left side views shows the printer's rear and left side views with parts identified in Table 4 rear and left side parts identification.

**Figure 5 VersaLink® B605 and B615 MFP rear and left side view**

1. Transfer roller	7. USB port, type A
2. Fuser	8. USB port, type B
3. Rear door	9. Ethernet connection
4. Wireless network adapter port cover	10. FDI port
5. Phone connector	11. Left-side panel (access to optional Productivity Kit)
6. FAX line connector	12. Power connector

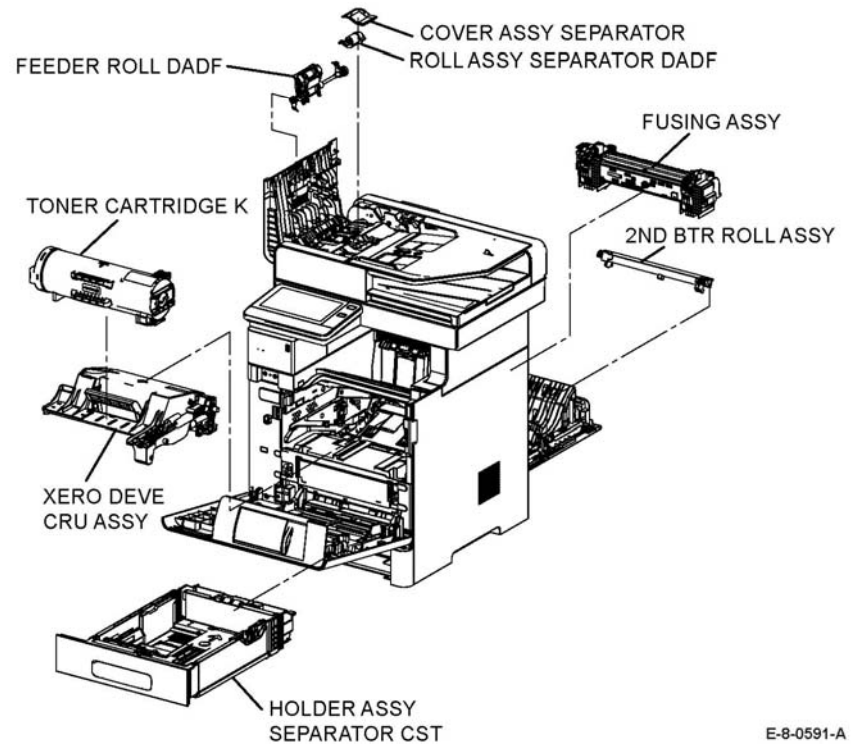
E-8-0591-A

Figure 6 shows the printer's front and right side view with internal parts.

**Figure 6 VersaLink® B605/B615 version internal parts**

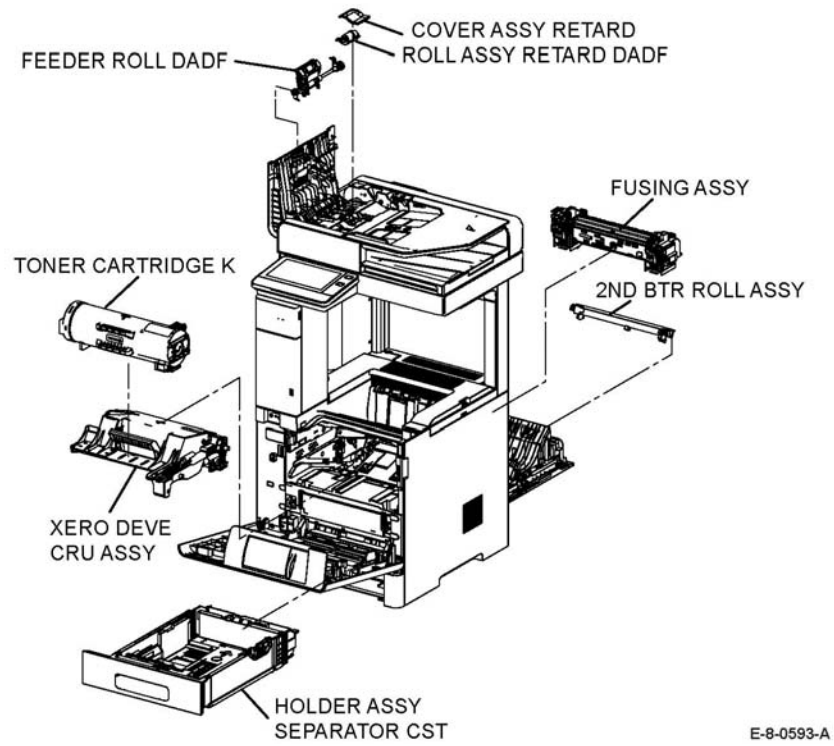
E-8-0593-A

Figure 7 shows the printer's front and right side view with internal parts.

**Figure 7 VersaLink® B615\_Tall version internal parts**

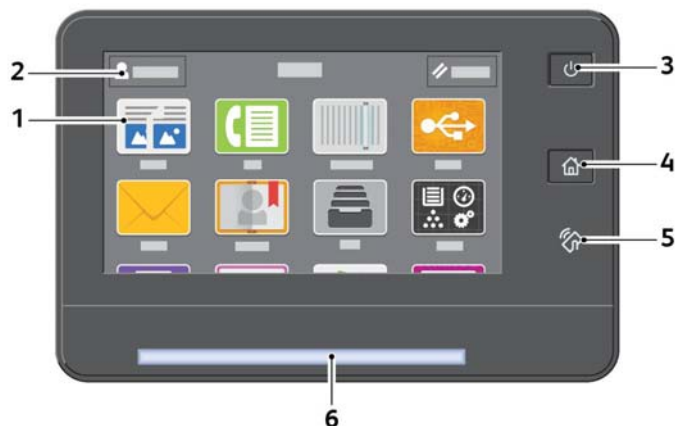
E-8-0929-A

The VersaLink® B605/B615 and B615\_Tall Version Control panel shown in **Figure 8**, consists of a touchscreen, a keypad, and several buttons. These buttons are used to navigate the menu system, perform functions, and select operational modes. **Table 5** lists the function of each control.

**Figure 8 VersaLink® B605/B615 and B615\_Tall version control panel**

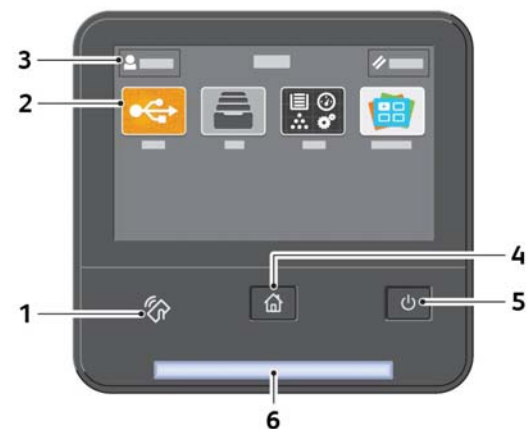
E-8-0930-A

The VersaLink® B600 and B610 control panel shown in **Figure 9**, consists of a touch screen, a keypad, and several buttons. These buttons are used to navigate the menu system, perform functions, and select operational modes. **Table 6** lists the function of each control.

**Figure 9 VersaLink® B600 and B610 control panel**

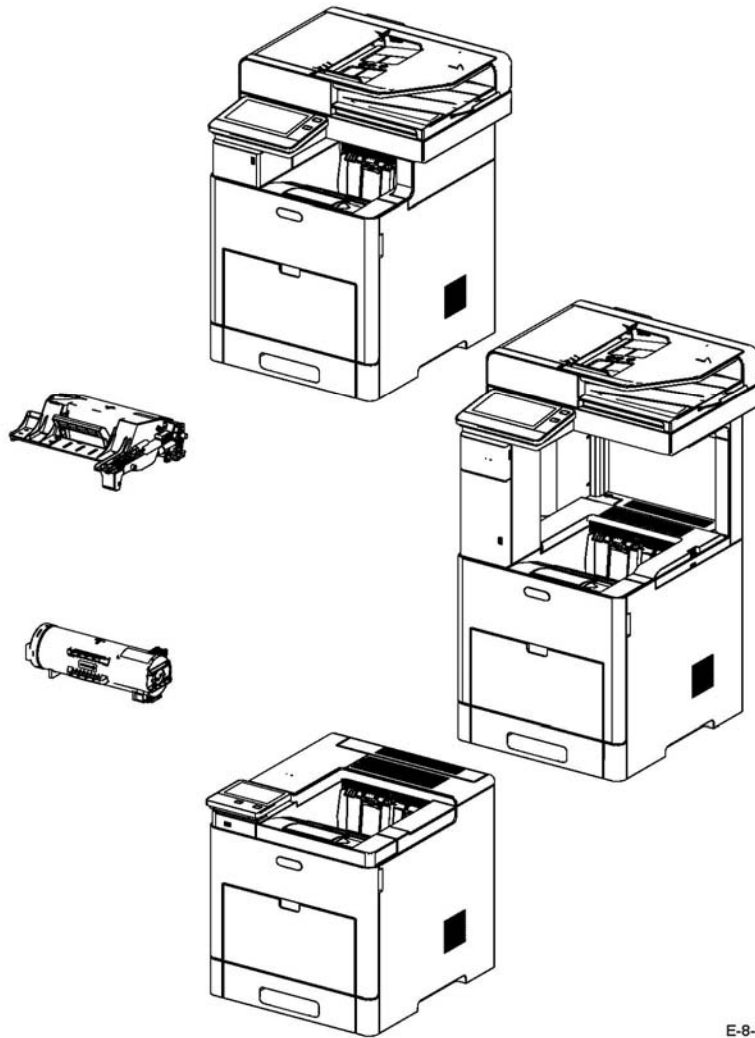
E-8-0574-A

The printer has the basic configurations depending on the destination. See Figure 10.

- Print engine main unit (MSI and 250 feeder unit as the standard paper feeding)
- Consumables (CRU)

Figure 10 Basic configuration

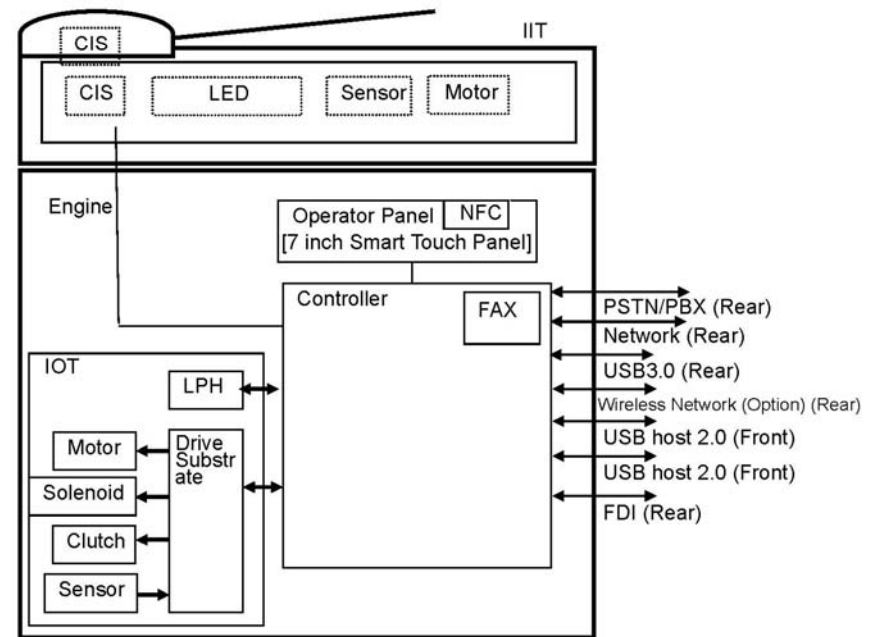
E-8-0575-A

The functional configuration for this printer is shown in Figure 11.

Figure 11 MFP functional configuration

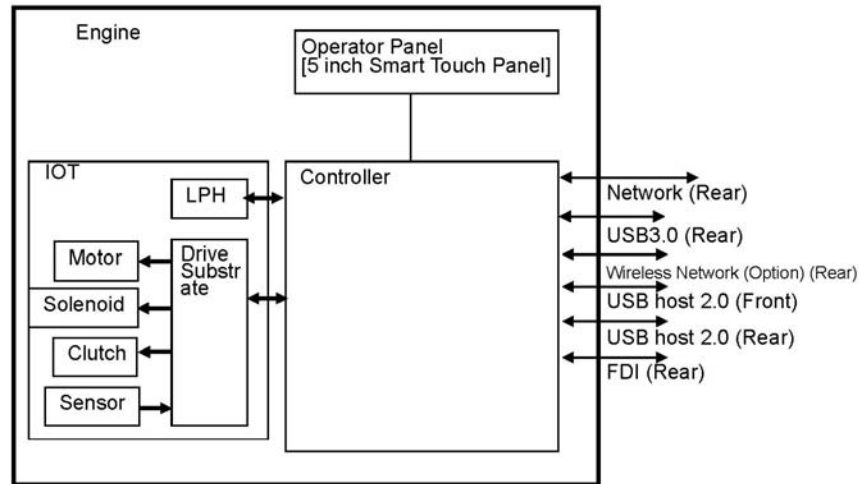
E-8-0576-A

The functional configuration for the SFP printer is shown in Figure 12.

Figure 12 SFP functional configuration

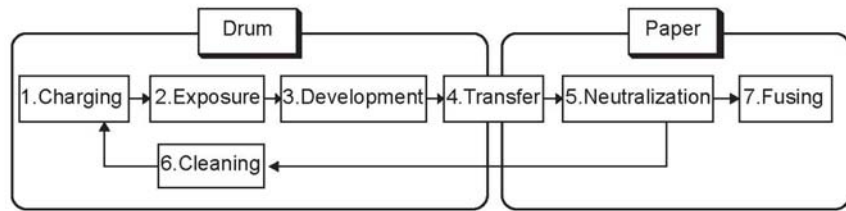
E-8-0623-A

1. Charging: The drum surface is electrically charged.
2. Exposure: The image is formed on the drum surface by the light from the LED (Light-Emitting Diodes).
3. Development: The image is developed with toner.
4. Transfer: The toner image on the drum surface is transferred onto the paper.
5. Neutralization: Electric charge of the paper is eliminated.
6. Cleaning: Excess toner on the drum, BCR and BTR is removed and transported to the waste toner collection area.
7. Fusing: The toner is fixed to the print medium by heat and pressure.

Figure 1 shows the printing process flow.

Figure 1 Printing process flow

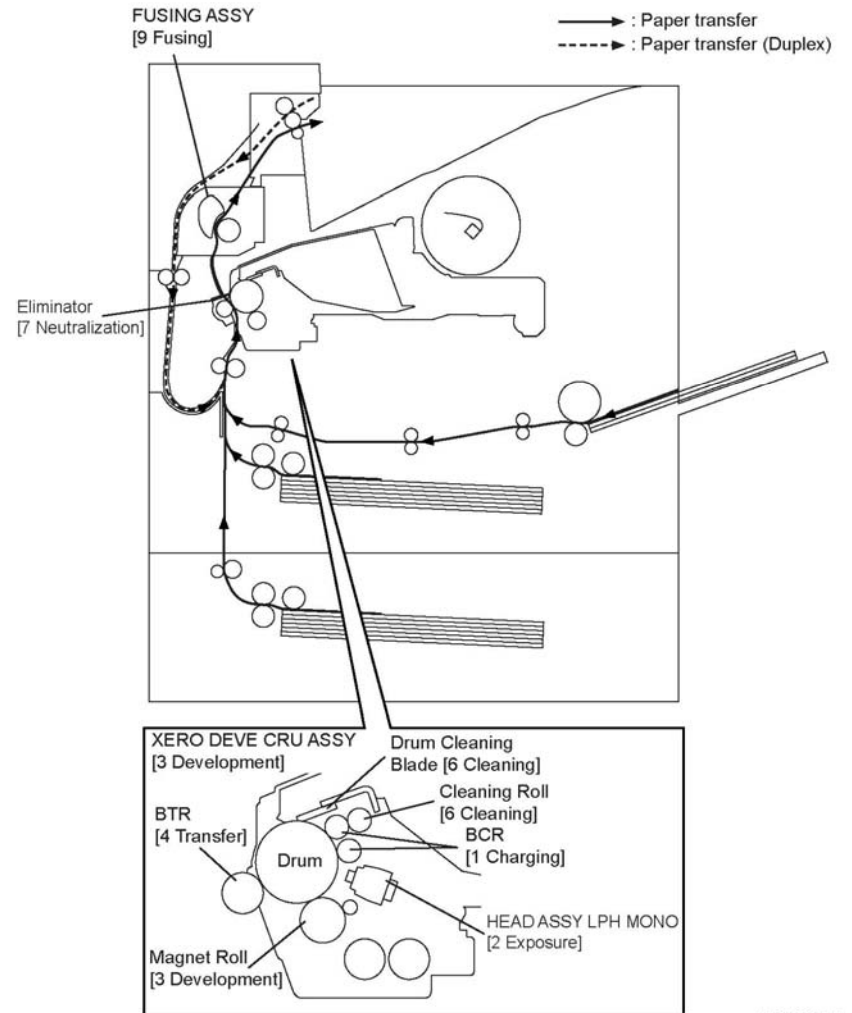
E-8-0624-A

Figure 2 shows the printing process functions outline.

Figure 2 Printing process functions

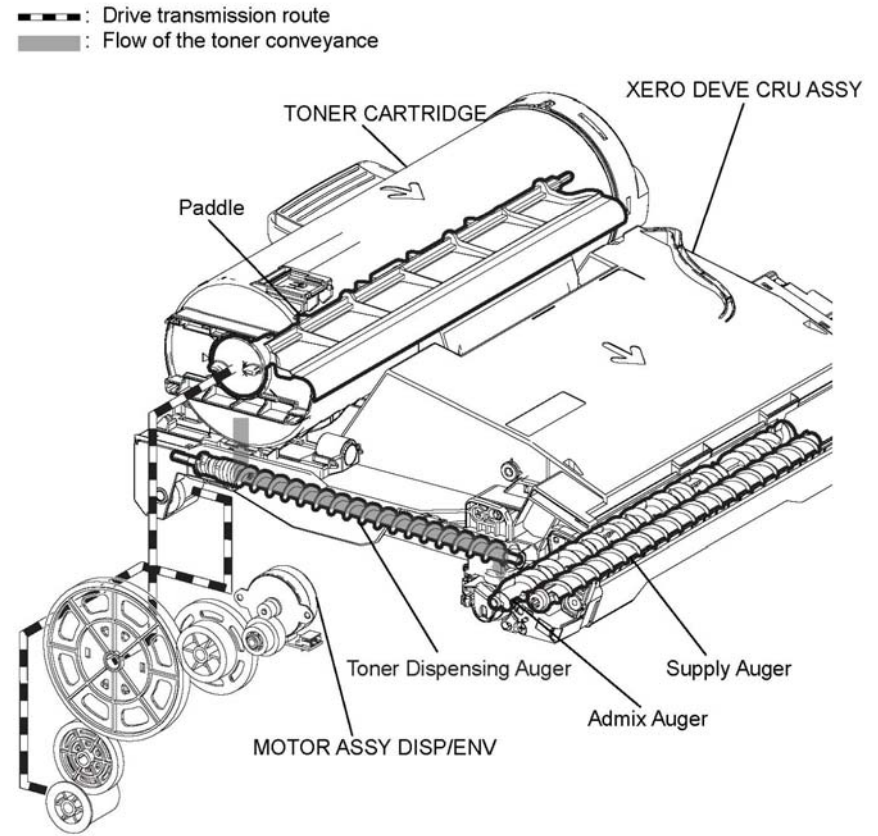
E-8-0628-A

The toner supplied from the toner cartridge is fed into the drum cartridge by the toner dispensing auger in the drum cartridge and the paddle in the toner cartridge driven by the motor assembly disp/env.

Figure 3 Toner dispensing during development

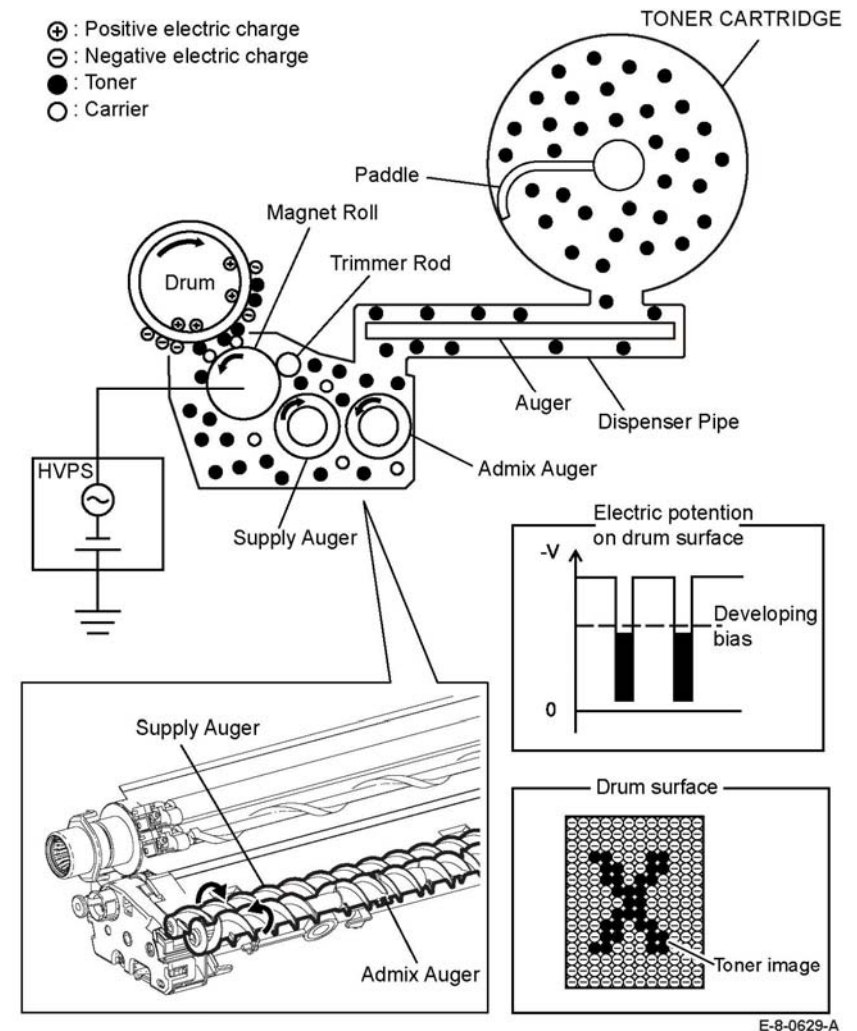
In the developer section, the incoming toner is mixed with the existing developer (toner/carrier mixture) by the admix auger and the supply auger, and then supplied to the magnet roll located near the drum surface as shown in Figure 4. The toner and carrier are charged by friction due to agitation (toner in negative, carrier in positive), and they attract each other electrically. The carrier, due to its magnetic properties, is attracted to the magnet roll, and then uniformly leveled by the trimmer rod.

The magnet roll is covered by a thin semi-conductive sleeve all over the surface. The DB (Developing Bias) voltage is supplied to this semiconductor sleeve from the High Voltage Power Supply (HVPS). The DB voltage is negative DC voltage combined with AC voltage. The DC voltage keeps the magnet roll at a constant negative voltage against the photoreceptor layer of the drum. Therefore, at the area where the negative electric charge on the drum surface does not decrease, the potential is lower than that of the magnet roll, while the potential is higher than that of the magnet roll at the area where the negative charge on the drum surface decreases. The AC voltage shakes the developer on the surface of the magnet roll so that the toner easily flies to the drum. Thus, only the portions of the drum surface where the negative charge has decreased below that of the magnet roll (electrostatic latent image) attract the toner to form an image on the drum. Once the toner is deposited on the drum, the potential and the toner-attracting force of the corresponding portion decreases because the increase of negative charge lowers the potential at that portion.

Figure 4 Development process
